NC School District/995 Yancey County/High School

# Mountain Heritage High

## Campus Assessment Report

March 7, 2017

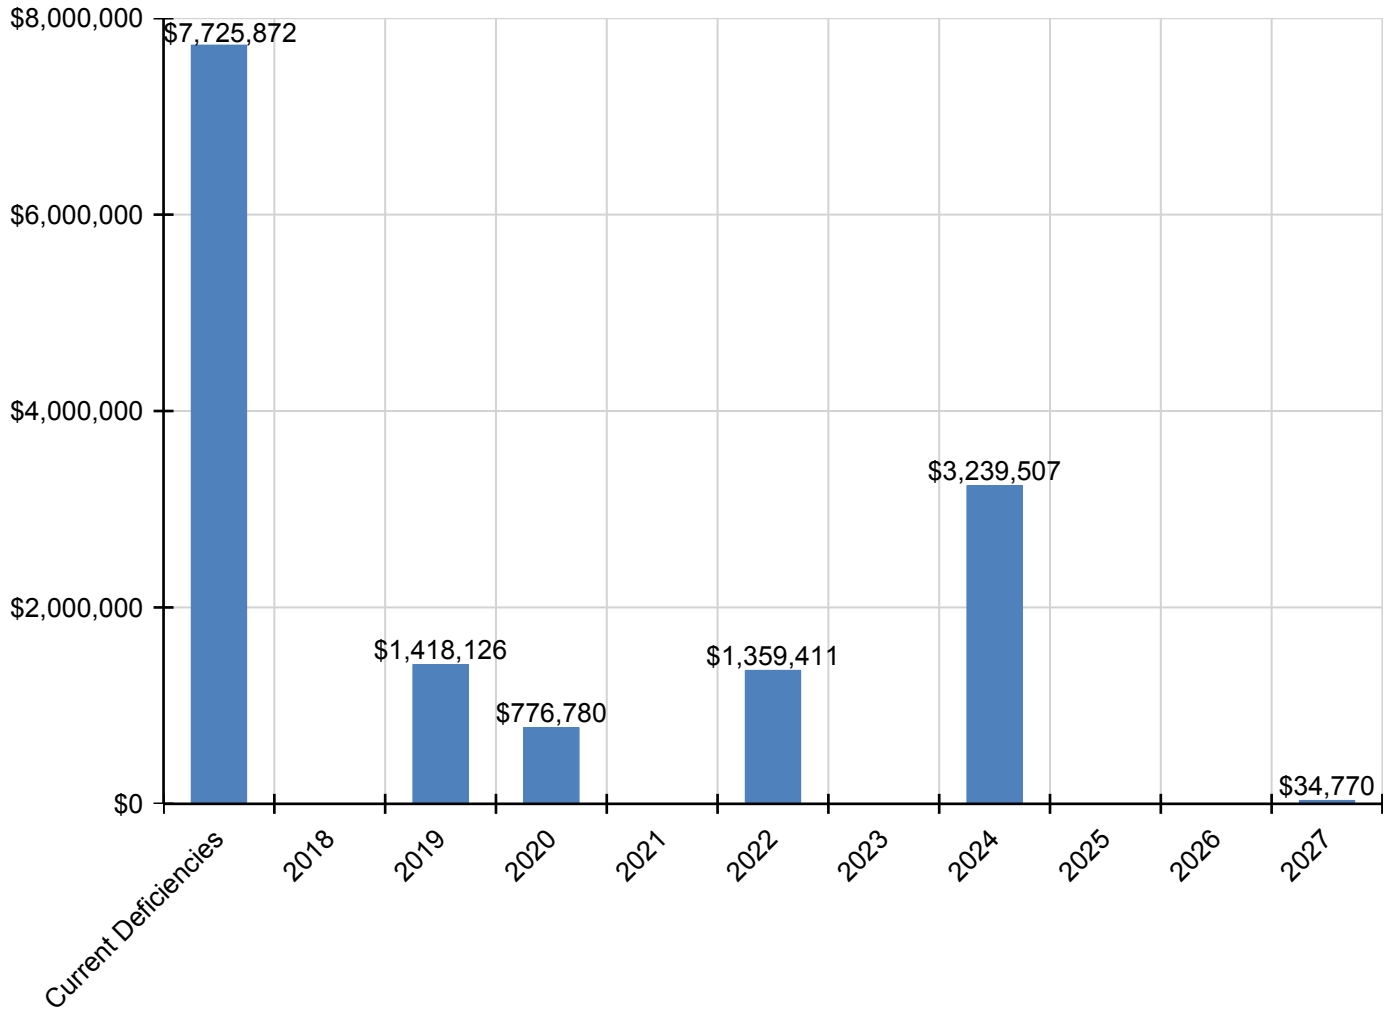
## Forecasted Capital Renewal Requirement

The following chart shows the current building deficiencies and forecasting capital renewal or sustainment requirements over the next ten years.

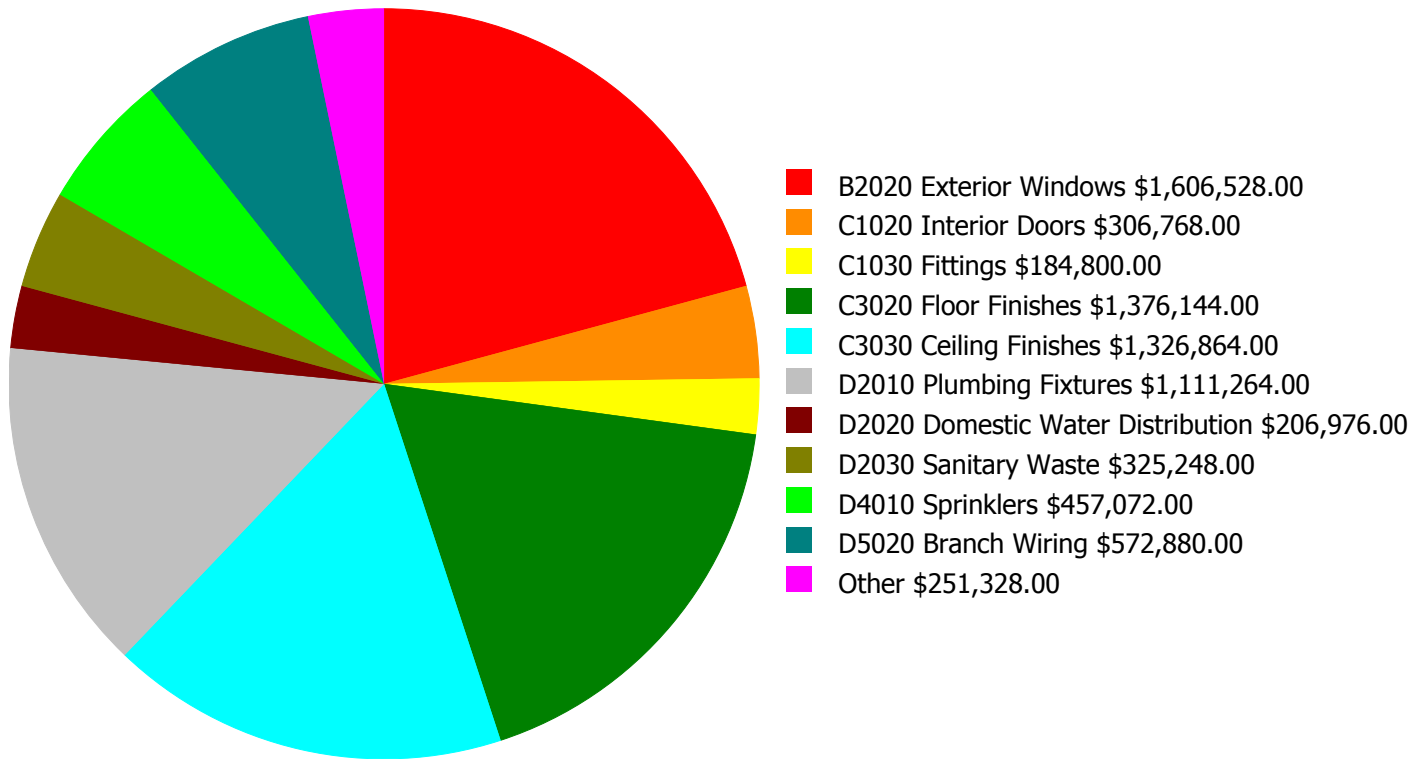
## Deficiency Summary by System

Current deficiencies included assemblies that have reached or exceeded their design life or components of the assemblies that are in need of repair. Assemblies that have reached their design life are identified as current deficiencies and assigned the distress 'Beyond Useful Life'. The following chart lists all current deficiencies associated with this facility.

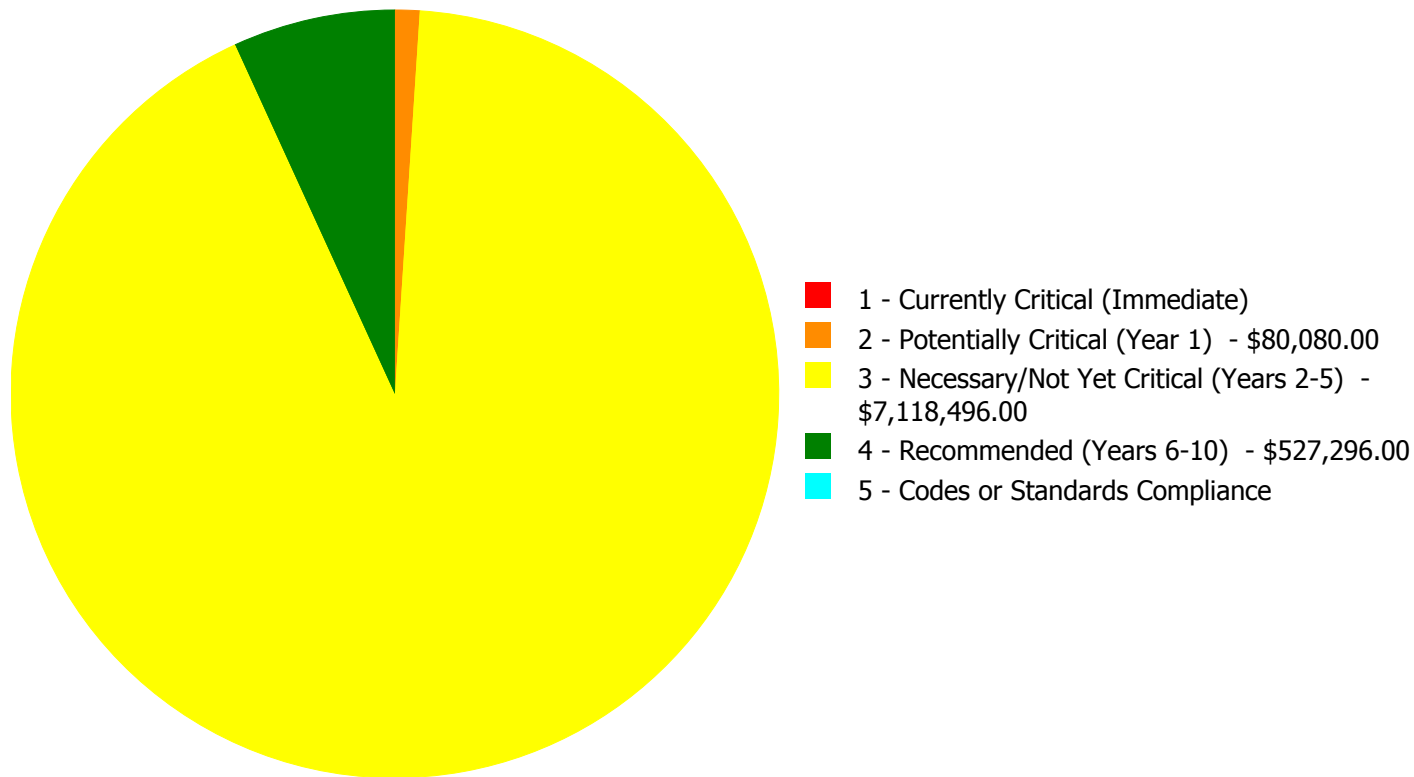
### Deficiency Summary by Priority

The following chart shows the total repair costs broken down by priority. Assessors assigned deficiencies within eCOMET to one of the following priority categories:

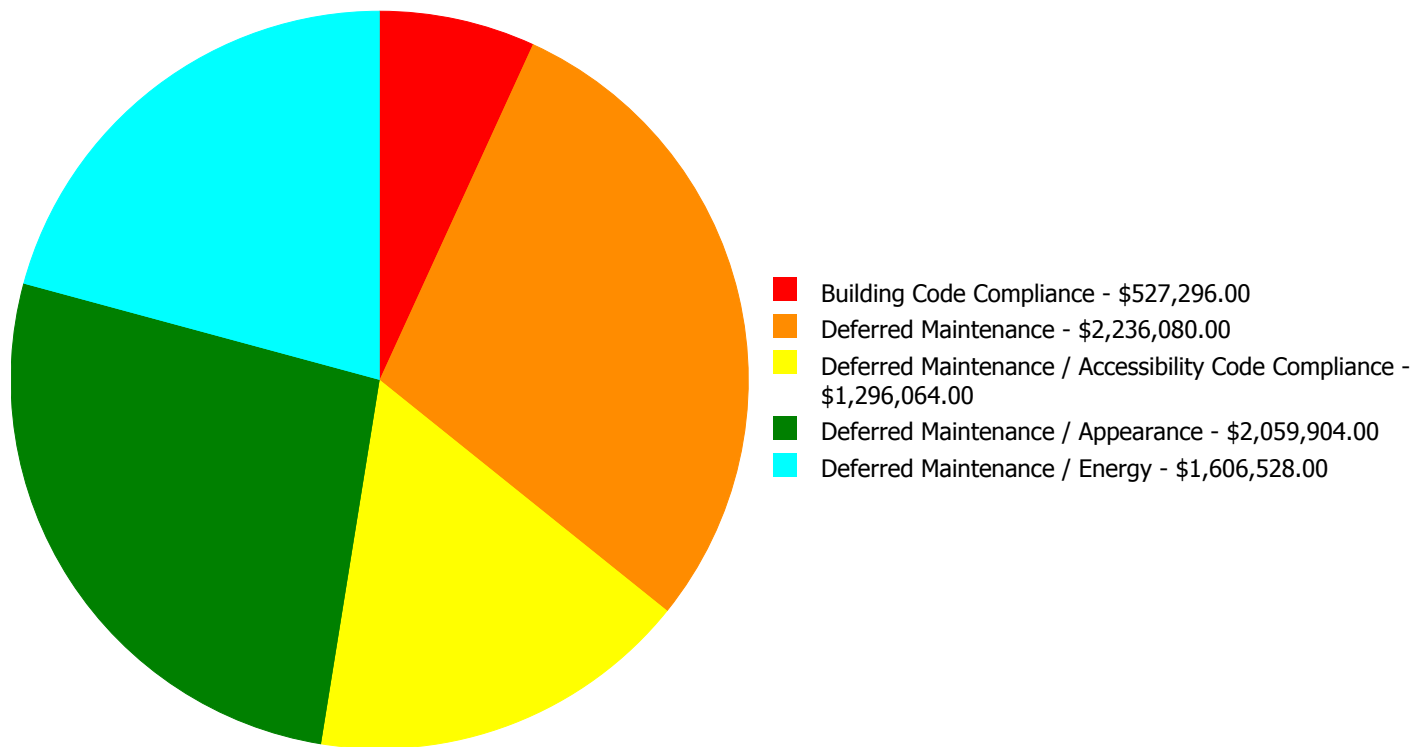
## Deficiency Summary by Category

The following chart shows the total repair costs broken down by deficiency categories. Assessors assigned deficiencies to one of the following categories:

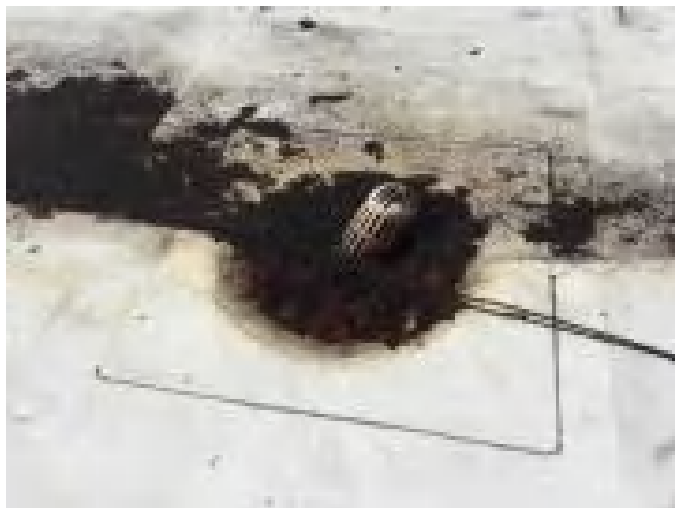
#### **System: D2040 - Rain Water Drainage**

**Location:** Throughout  
**Distress:** Failing  
**Category:** Deferred Maintenance  
**Priority:** 2 - Potentially Critical (Year 1)  
**Correction:** Renew System  
**Qty:** 112,000.00  
**Unit of Measure:** S.F.  
**Estimate:** \$80,080.00  
**Assessor Name:** Terence Davis  
**Date Created:** 01/25/2017

**Notes:** The rain water drainage system is aged, in poor condition, and should be replaced.  
Roof drains were not replaced with latest roof replacement and are causing interior leaks.

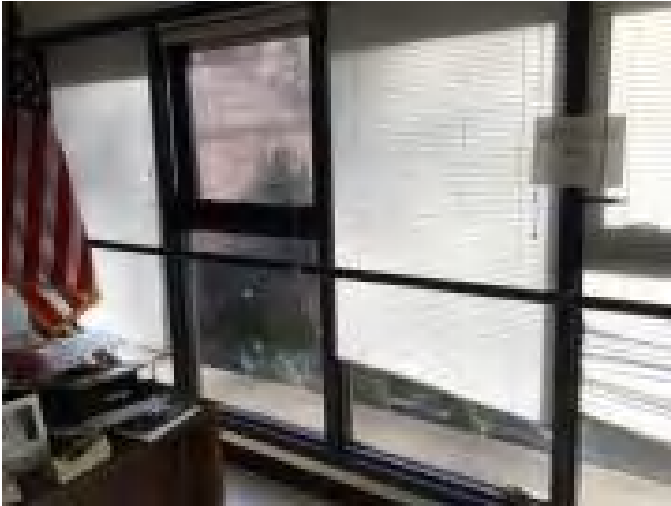
**System: B2020 - Exterior Windows**

**Location:** Throughout  
**Distress:** Beyond Service Life  
**Category:** Deferred Maintenance / Energy  
**Priority:** 3 - Necessary/Not Yet Critical (Years 2-5)  
**Correction:** Renew System  
**Qty:** 112,000.00  
**Unit of Measure:** S.F.  
**Estimate:** \$1,606,528.00  
**Assessor Name:** Terence Davis  
**Date Created:** 01/25/2017

**Notes:** The aluminum frame, operable, single pane windows are aged, rusted, not energy efficient, and should be replaced.

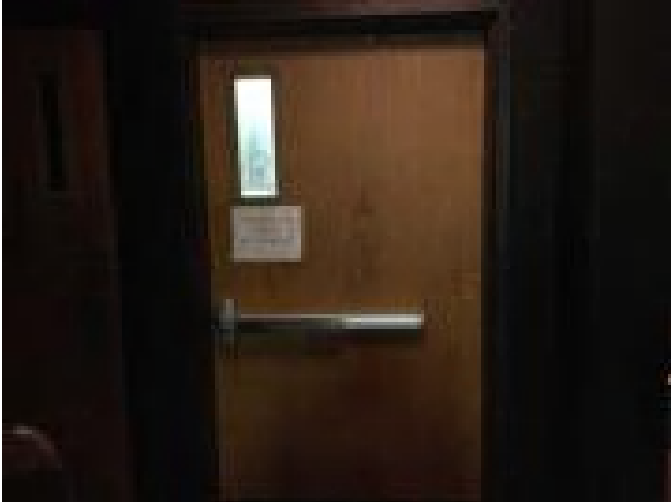
**System: B2030 - Exterior Doors**

**Location:** Throughout  
**Distress:** Failing  
**Category:** Deferred Maintenance / Appearance  
**Priority:** 3 - Necessary/Not Yet Critical (Years 2-5)  
**Correction:** Renew System  
**Qty:** 112,000.00  
**Unit of Measure:** S.F.  
**Estimate:** \$101,024.00  
**Assessor Name:** Terence Davis  
**Date Created:** 01/25/2017

**Notes:** The original exterior doors are aged, rusted, and should be replaced.

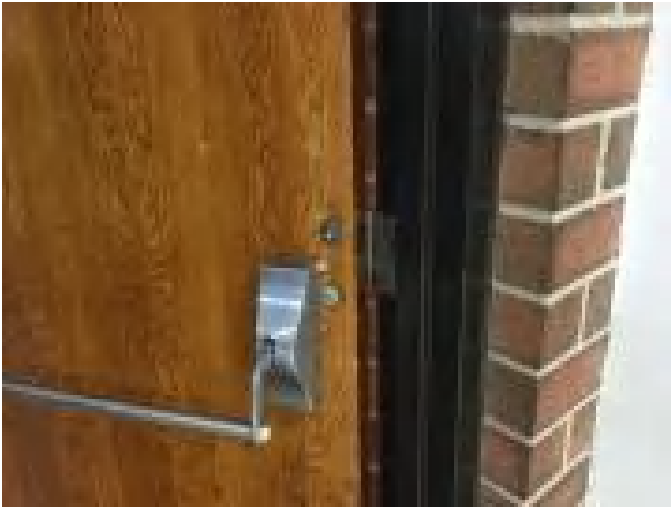
**System: C1020 - Interior Doors**

**Location:** Throughout  
**Distress:** Failing  
**Category:** Deferred Maintenance / Appearance  
**Priority:** 3 - Necessary/Not Yet Critical (Years 2-5)  
**Correction:** Renew System  
**Qty:** 112,000.00  
**Unit of Measure:** S.F.  
**Estimate:** \$306,768.00  
**Assessor Name:** Terence Davis  
**Date Created:** 01/25/2017

**Notes:** The interior doors are aged, failing, most hardware is not ADA or code compliant and should be replaced.

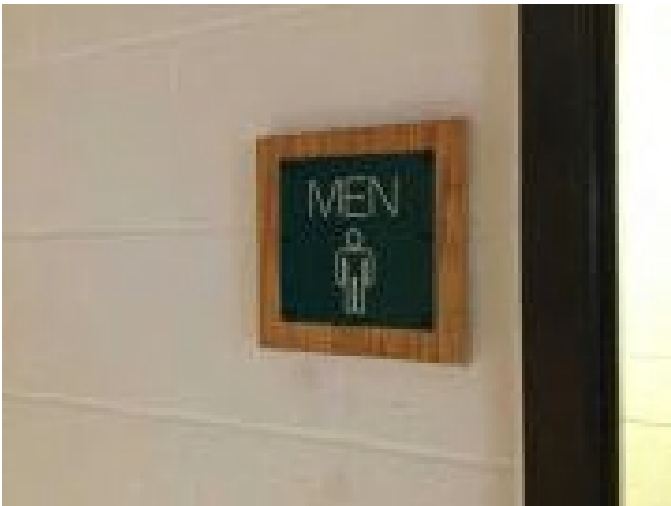
**System: C1030 - Fittings**

**Location:** Throughout  
**Distress:** Beyond Service Life  
**Category:** Deferred Maintenance / Accessibility Code Compliance  
**Priority:** 3 - Necessary/Not Yet Critical (Years 2-5)  
**Correction:** Renew System  
**Qty:** 112,000.00  
**Unit of Measure:** S.F.  
**Estimate:** \$184,800.00  
**Assessor Name:** Terence Davis  
**Date Created:** 01/25/2017

**Notes:** The fittings throughout the building are aged, in marginal condition, handrails and room signage are ADA non-compliance and system should be replaced.

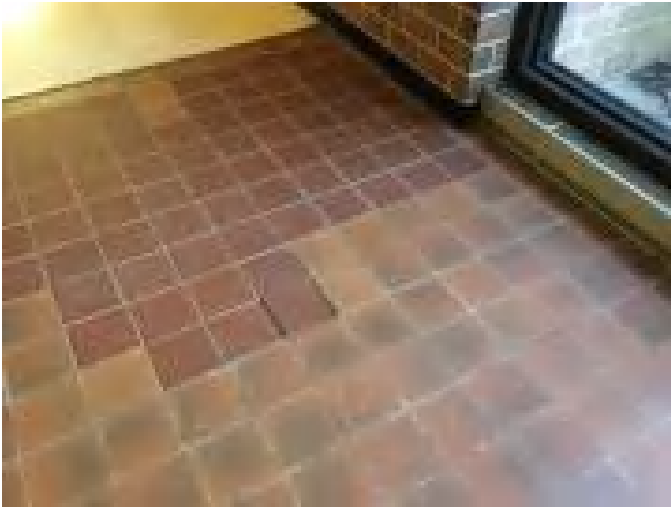
**System: C3020 - Floor Finishes**

**Location:** Throughout  
**Distress:** Beyond Service Life  
**Category:** Deferred Maintenance  
**Priority:** 3 - Necessary/Not Yet Critical (Years 2-5)  
**Correction:** Renew System  
**Qty:** 112,000.00  
**Unit of Measure:** S.F.  
**Estimate:** \$1,376,144.00  
**Assessor Name:** Terence Davis  
**Date Created:** 01/25/2017

**Notes:** The quarry tile in corridor spaces is chipped, cracked, and failing due to installation over existing damaged VCT. Full removal and replacement is recommended.  
The carpet is aged, stained, frayed, and should be replaced.  
The VCT flooring is aged, cracked, worn, and should be replaced.

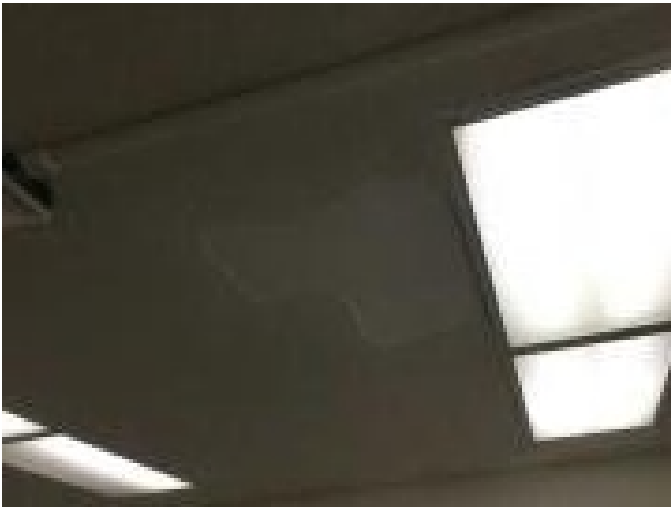
**System: C3030 - Ceiling Finishes**

**Location:** Throughout  
**Distress:** Beyond Service Life  
**Category:** Deferred Maintenance / Appearance  
**Priority:** 3 - Necessary/Not Yet Critical (Years 2-5)  
**Correction:** Renew System  
**Qty:** 112,000.00  
**Unit of Measure:** S.F.  
**Estimate:** \$1,326,864.00  
**Assessor Name:** Terence Davis  
**Date Created:** 01/25/2017

**Notes:** The original ceiling finishes are aged, failing and should be replaced.

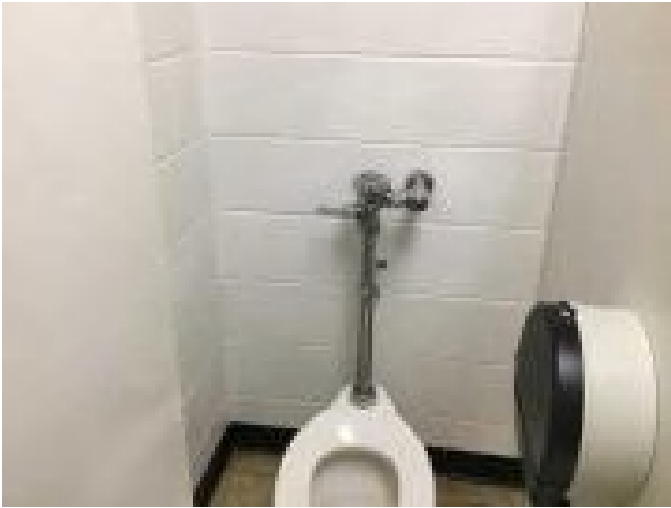
**System: D2010 - Plumbing Fixtures**

**Location:** Throughout  
**Distress:** Beyond Service Life  
**Category:** Deferred Maintenance / Accessibility Code Compliance  
**Priority:** 3 - Necessary/Not Yet Critical (Years 2-5)  
**Correction:** Renew System  
**Qty:** 112,000.00  
**Unit of Measure:** S.F.  
**Estimate:** \$1,111,264.00  
**Assessor Name:** Terence Davis  
**Date Created:** 01/25/2017

**Notes:** Plumbing fixtures are in operational conditions. However, they are aged, not ADA compliant and should be replaced with a low-flow water fixtures.

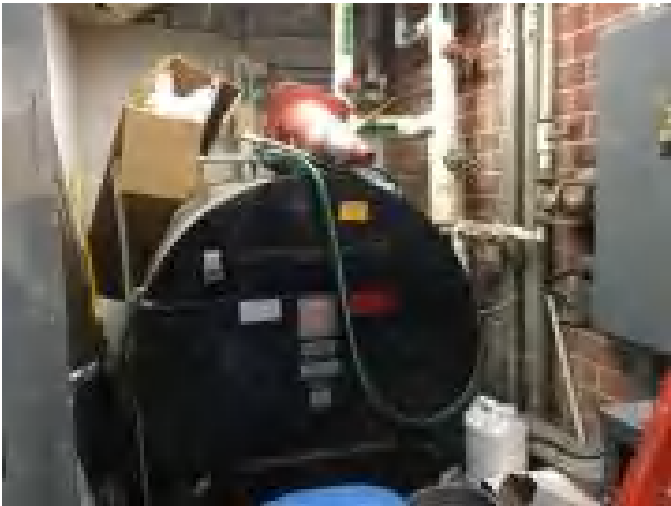
**System: D2020 - Domestic Water Distribution**

**Location:** Various  
**Distress:** Beyond Service Life  
**Category:** Deferred Maintenance  
**Priority:** 3 - Necessary/Not Yet Critical (Years 2-5)  
**Correction:** Renew System  
**Qty:** 112,000.00  
**Unit of Measure:** S.F.  
**Estimate:** \$206,976.00  
**Assessor Name:** Terence Davis  
**Date Created:** 01/25/2017

**Notes:** The domestic water distribution system is aged and should be replaced.  
Some hot water heating systems have failed and are abandoned in place and service not restored in those areas.

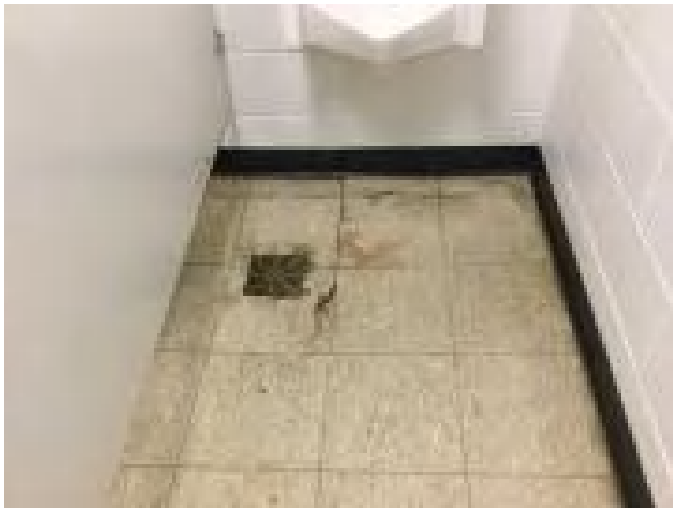
**System: D2030 - Sanitary Waste**

**Location:** Throughout  
**Distress:** Beyond Service Life  
**Category:** Deferred Maintenance / Appearance  
**Priority:** 3 - Necessary/Not Yet Critical (Years 2-5)  
**Correction:** Renew System  
**Qty:** 112,000.00  
**Unit of Measure:** S.F.  
**Estimate:** \$325,248.00  
**Assessor Name:** Terence Davis  
**Date Created:** 01/25/2017

**Notes:** The sanitary waste system is aged, has reported periodic failures, and should be replaced.

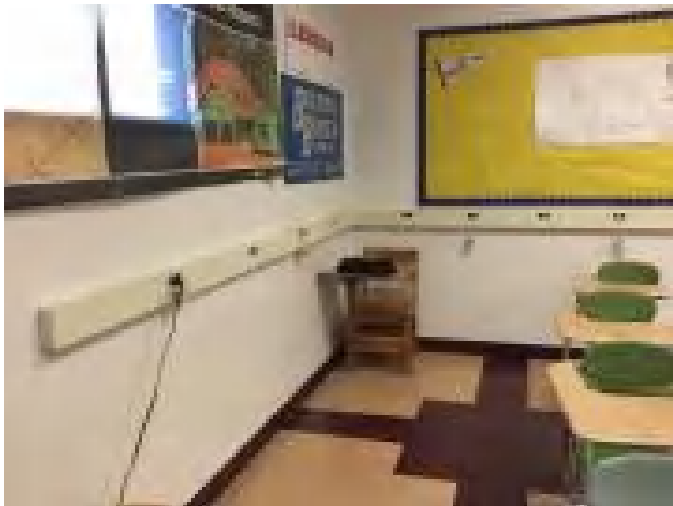
**System: D5020 - Branch Wiring**

**Location:** Throughout  
**Distress:** Beyond Service Life  
**Category:** Deferred Maintenance  
**Priority:** 3 - Necessary/Not Yet Critical (Years 2-5)  
**Correction:** Renew System  
**Qty:** 112,000.00  
**Unit of Measure:** S.F.  
**Estimate:** \$572,880.00  
**Assessor Name:** Terence Davis  
**Date Created:** 01/25/2017

**Notes:** The branch wiring system is operating, but is aged, in poor condition, and should be replaced.

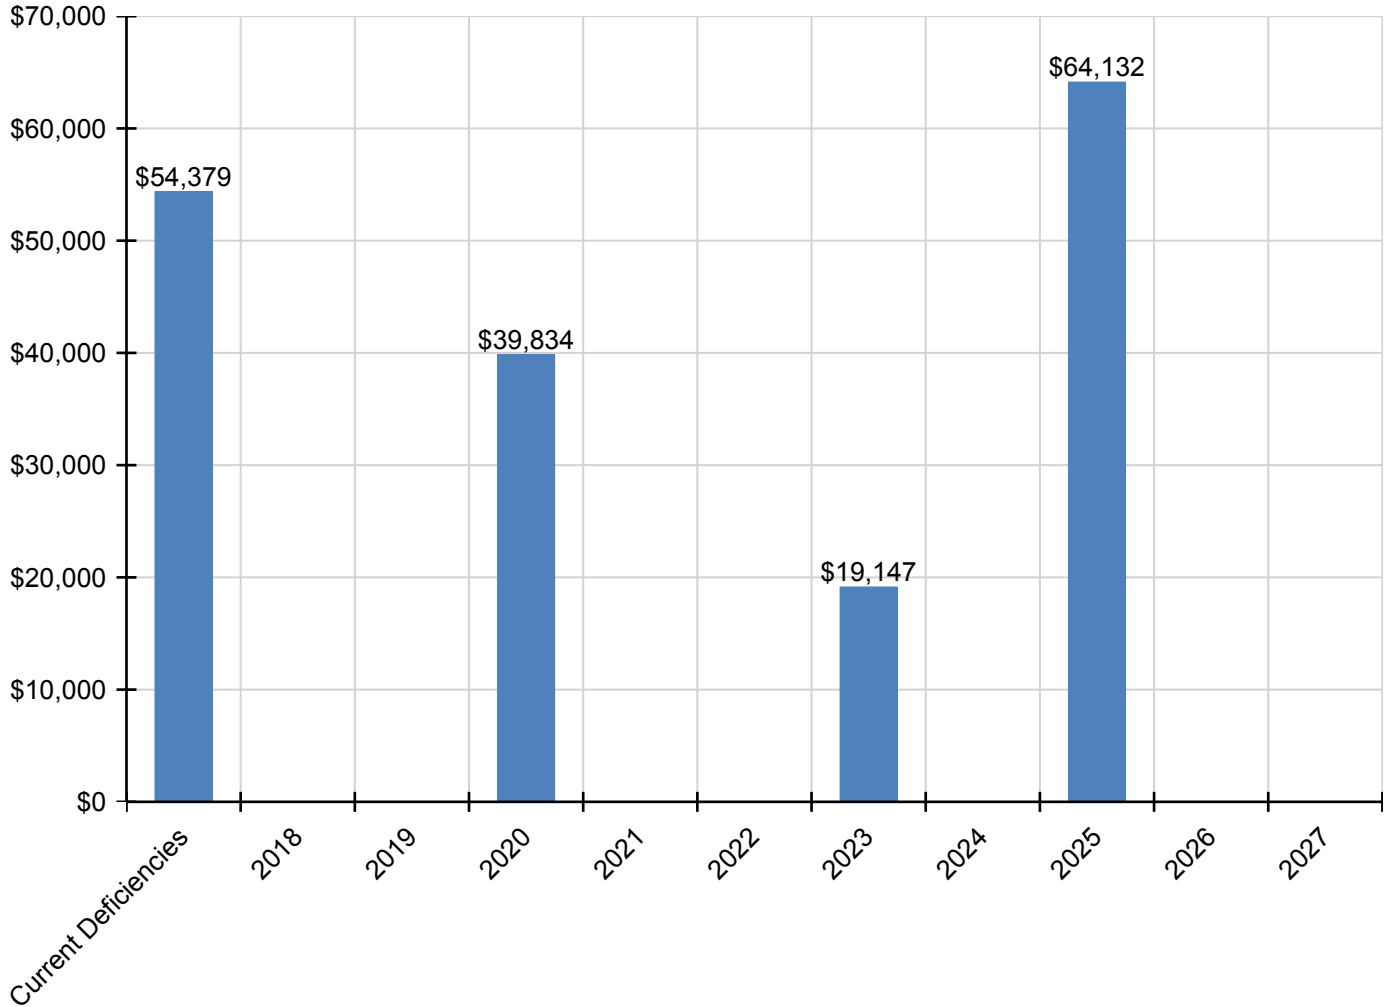
## Forecasted Capital Renewal Requirement

The following chart shows the current building deficiencies and forecasting capital renewal or sustainment requirements over the next ten years.

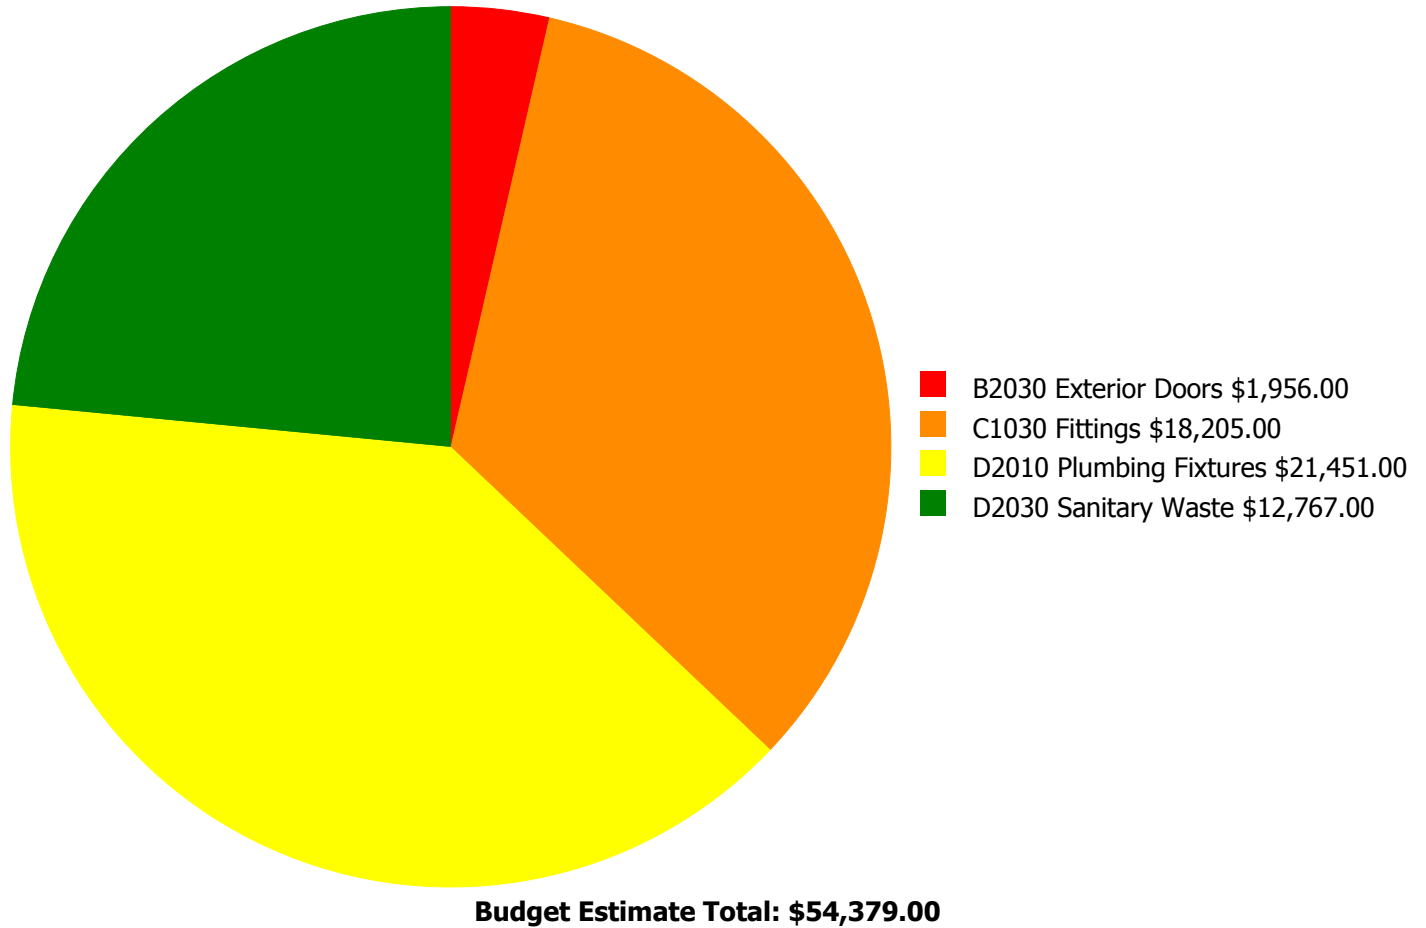
## Deficiency Summary by System

Current deficiencies included assemblies that have reached or exceeded their design life or components of the assemblies that are in need of repair. Assemblies that have reached their design life are identified as current deficiencies and assigned the distress 'Beyond Useful Life'. The following chart lists all current deficiencies associated with this facility.

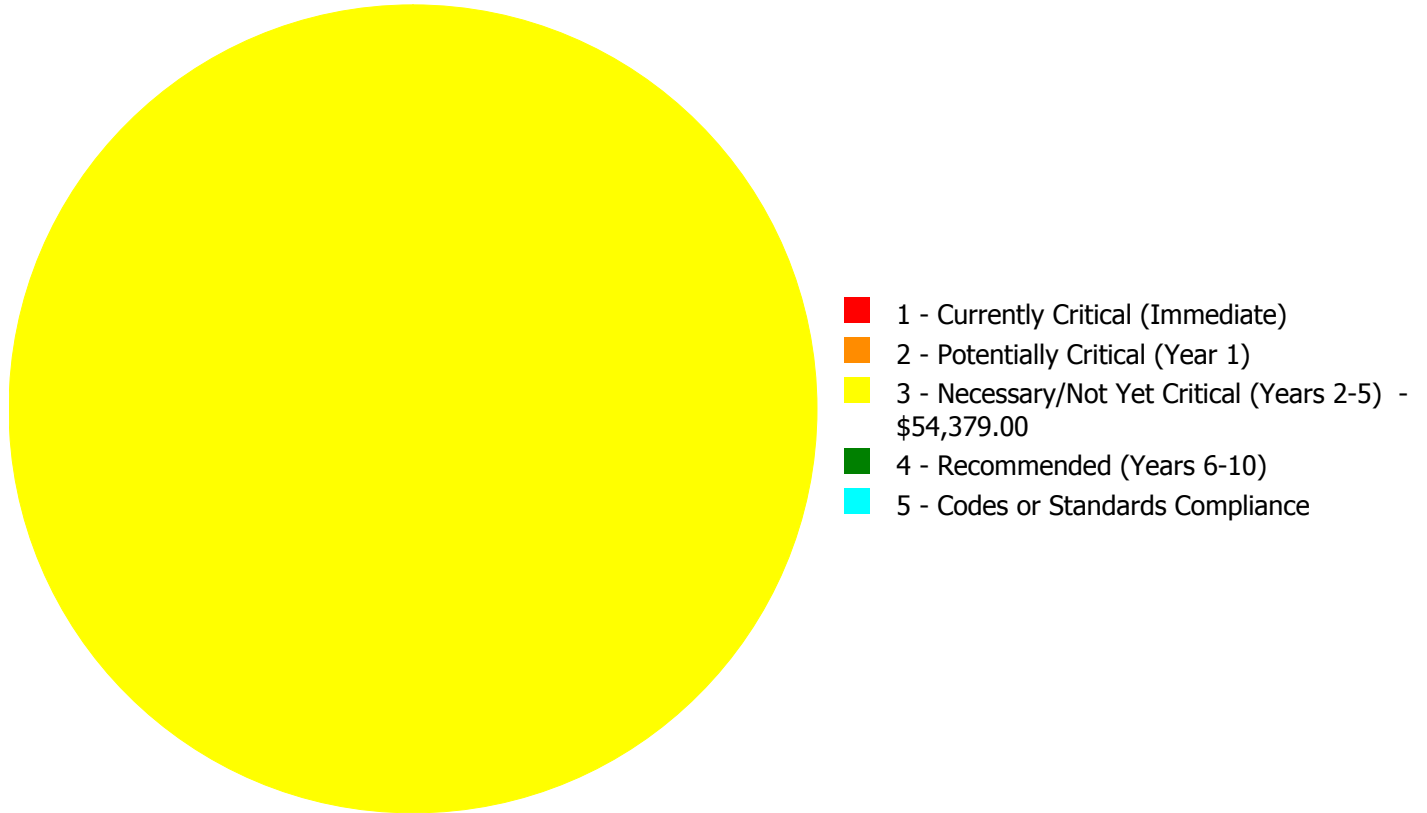
## Deficiency Summary by Priority

The following chart shows the total repair costs broken down by priority. Assessors assigned deficiencies within eCOMET to one of the following priority categories:

**Budget Estimate Total: \$54,379.00**

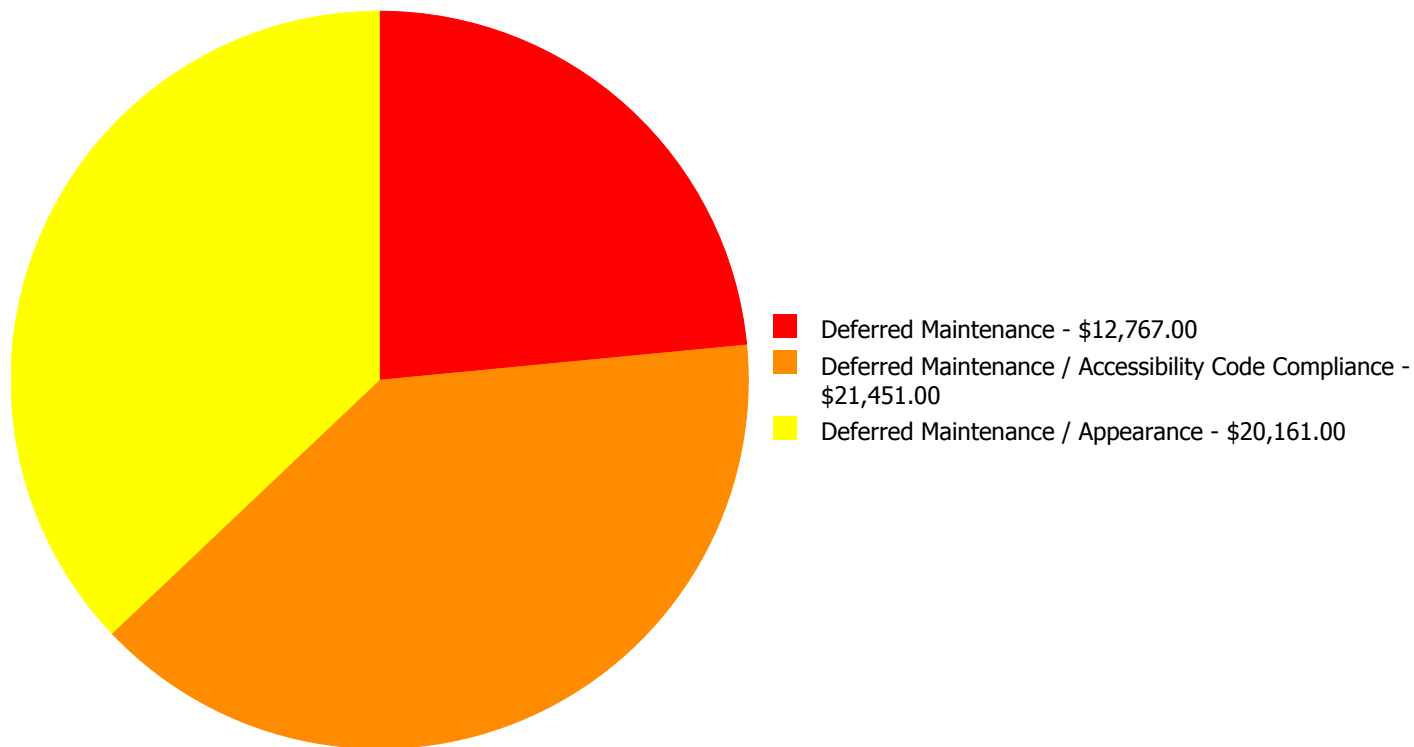
### Deficiency Summary by Category

The following chart shows the total repair costs broken down by deficiency categories. Assessors assigned deficiencies to one of the following categories:

**Budget Estimate Total: \$54,379.00**

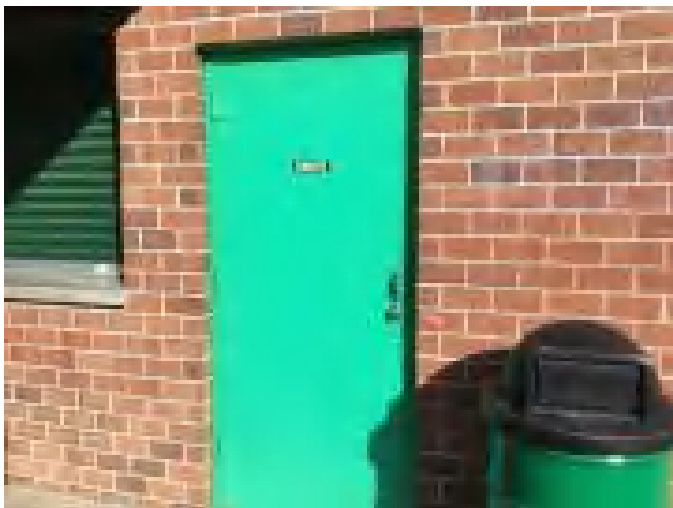
#### System: B2030 - Exterior Doors

**Location:** Concession  
**Distress:** Failing  
**Category:** Deferred Maintenance / Appearance  
**Priority:** 3 - Necessary/Not Yet Critical (Years 2-5)  
**Correction:** Renew System  
**Qty:** 1,954.00  
**Unit of Measure:** S.F.  
**Estimate:** \$1,956.00  
**Assessor Name:** Eduardo Lopez  
**Date Created:** 01/25/2017

**Notes:** The original exterior doors are aged, rusted, and should be replaced.

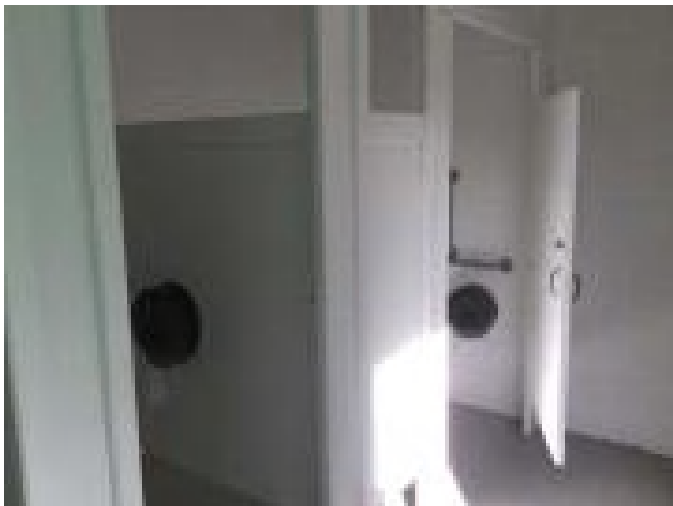
#### System: C1030 - Fittings

**Location:** Throughout  
**Distress:** Beyond Service Life  
**Category:** Deferred Maintenance / Appearance  
**Priority:** 3 - Necessary/Not Yet Critical (Years 2-5)  
**Correction:** Renew System  
**Qty:** 1,954.00  
**Unit of Measure:** S.F.  
**Estimate:** \$18,205.00  
**Assessor Name:** Eduardo Lopez  
**Date Created:** 01/25/2017

**Notes:** The fittings throughout the building are aged, in marginal condition, and should be replaced.

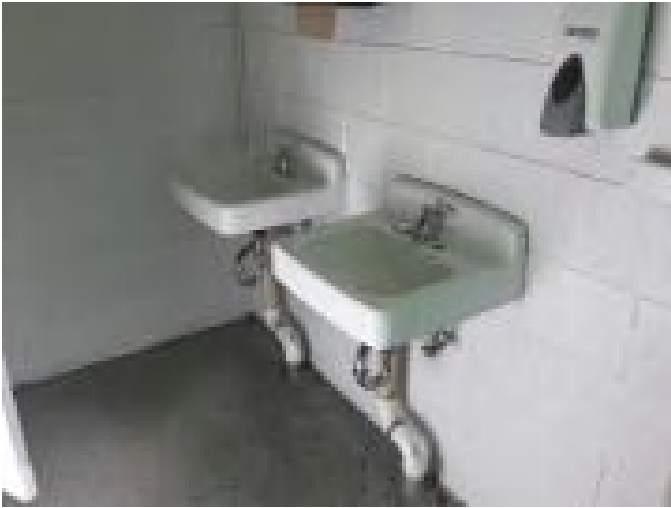
**System: D2010 - Plumbing Fixtures**

**Location:** Throughout  
**Distress:** Beyond Service Life  
**Category:** Deferred Maintenance / Accessibility Code Compliance  
**Priority:** 3 - Necessary/Not Yet Critical (Years 2-5)  
**Correction:** Renew System  
**Qty:** 1,954.00  
**Unit of Measure:** S.F.  
**Estimate:** \$21,451.00  
**Assessor Name:** Eduardo Lopez  
**Date Created:** 01/25/2017

**Notes:** Plumbing fixtures are in operational conditions. However, they are aged, not ADA compliant and should be replaced with a low-flow water fixtures.

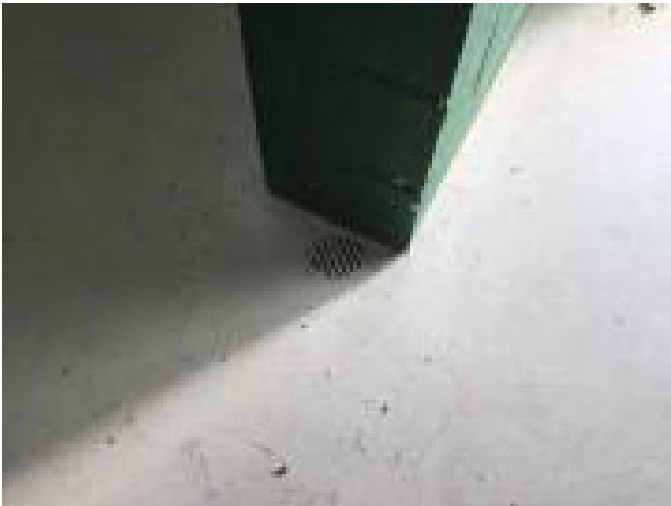
**System: D2030 - Sanitary Waste**

**Location:** Throughout  
**Distress:** Beyond Service Life  
**Category:** Deferred Maintenance  
**Priority:** 3 - Necessary/Not Yet Critical (Years 2-5)  
**Correction:** Renew System  
**Qty:** 1,954.00  
**Unit of Measure:** S.F.  
**Estimate:** \$12,767.00  
**Assessor Name:** Eduardo Lopez  
**Date Created:** 01/25/2017

**Notes:** The sanitary waste system is aged, has reported periodic failures, and should be replaced.

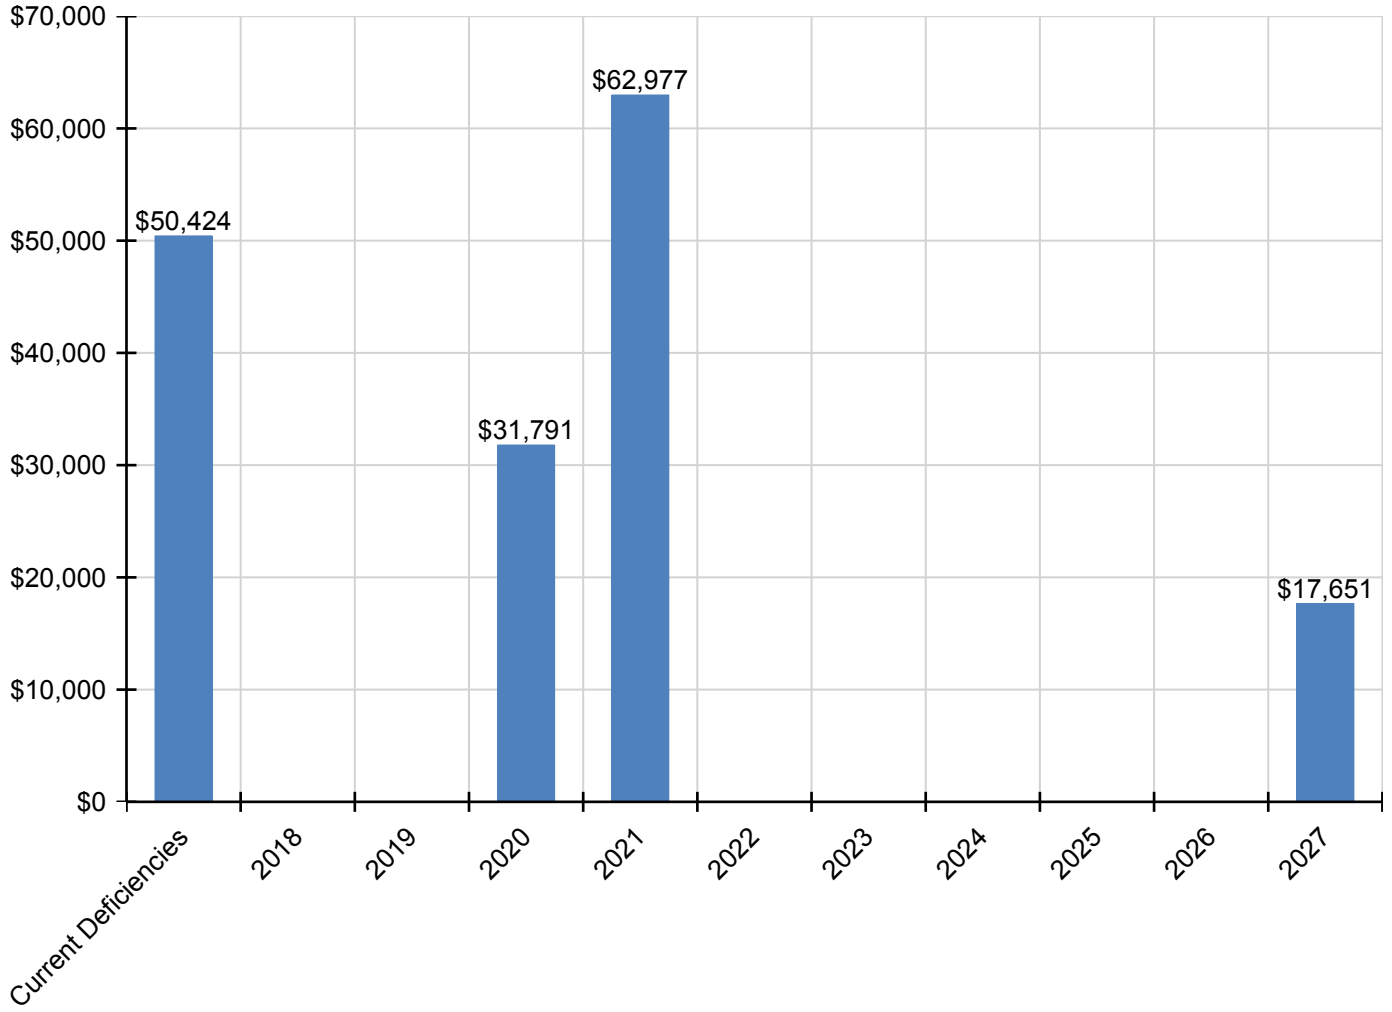
## Forecasted Capital Renewal Requirement

The following chart shows the current building deficiencies and forecasting capital renewal or sustainment requirements over the next ten years.

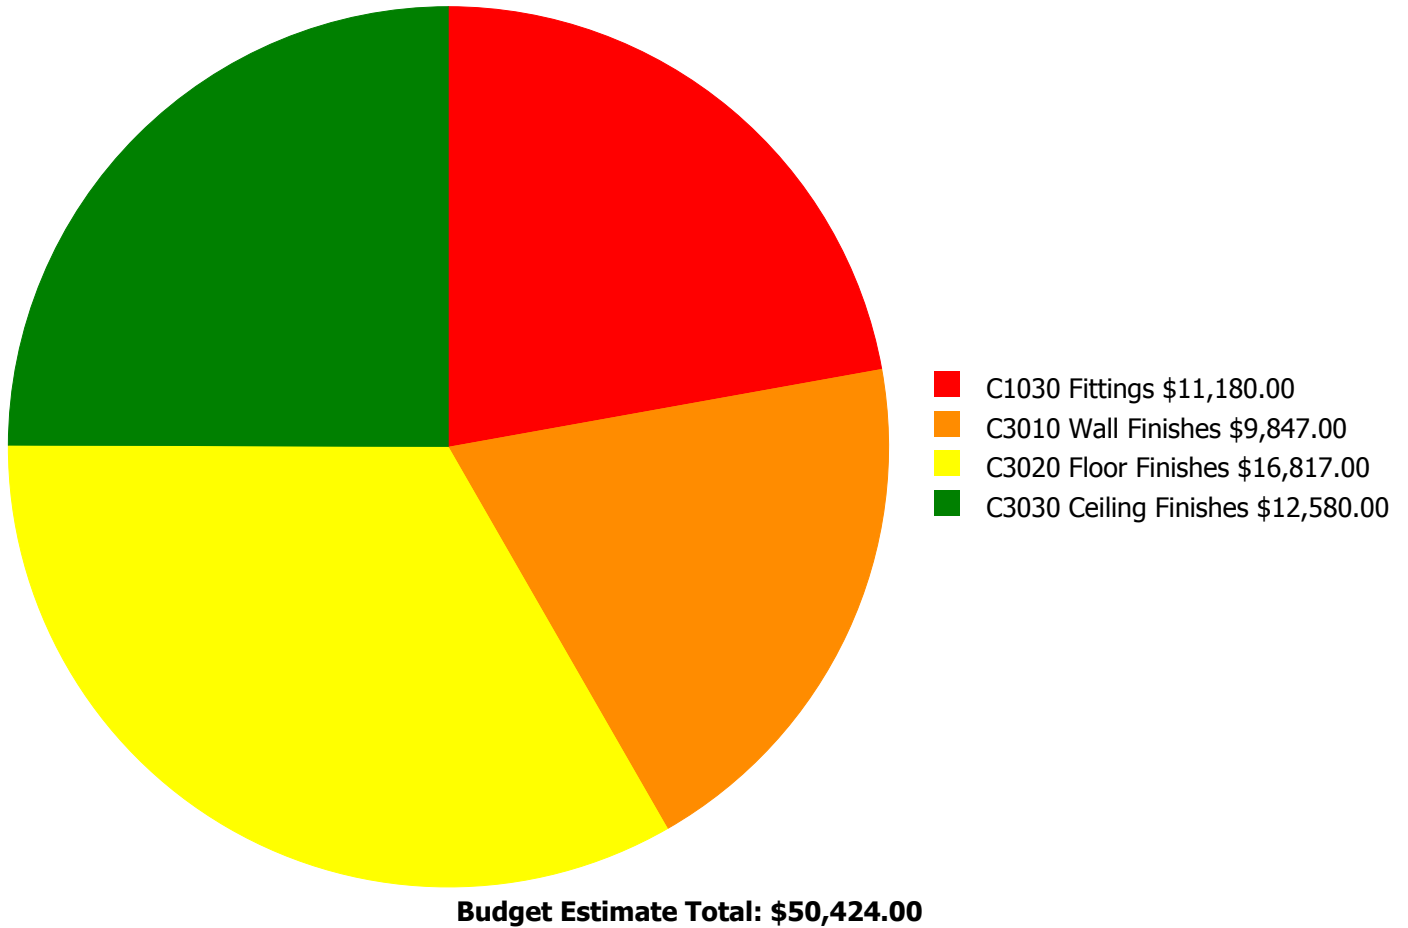
## Deficiency Summary by System

Current deficiencies included assemblies that have reached or exceeded their design life or components of the assemblies that are in need of repair. Assemblies that have reached their design life are identified as current deficiencies and assigned the distress 'Beyond Useful Life'. The following chart lists all current deficiencies associated with this facility.

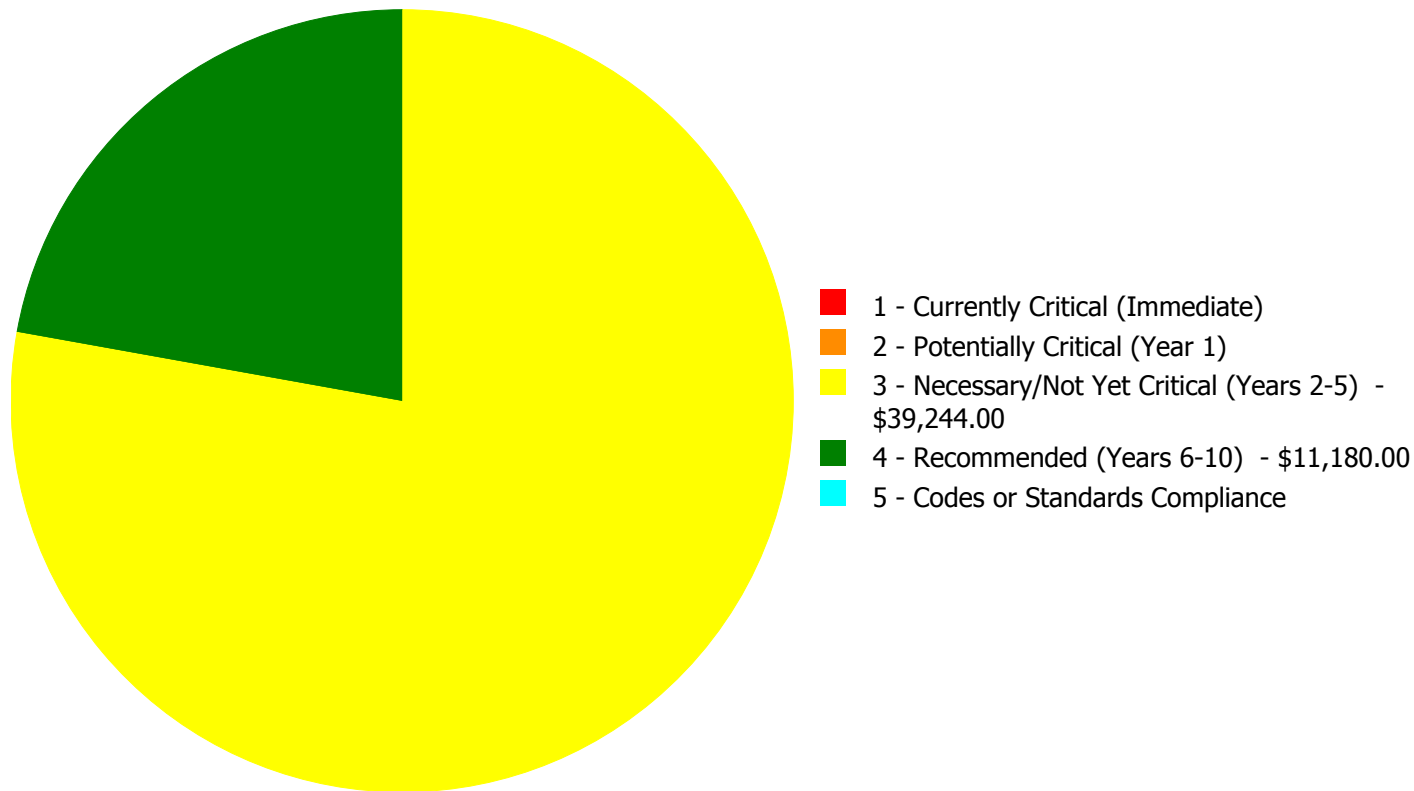
### Deficiency Summary by Priority

The following chart shows the total repair costs broken down by priority. Assessors assigned deficiencies within eCOMET to one of the following priority categories:

**Budget Estimate Total: \$50,424.00**

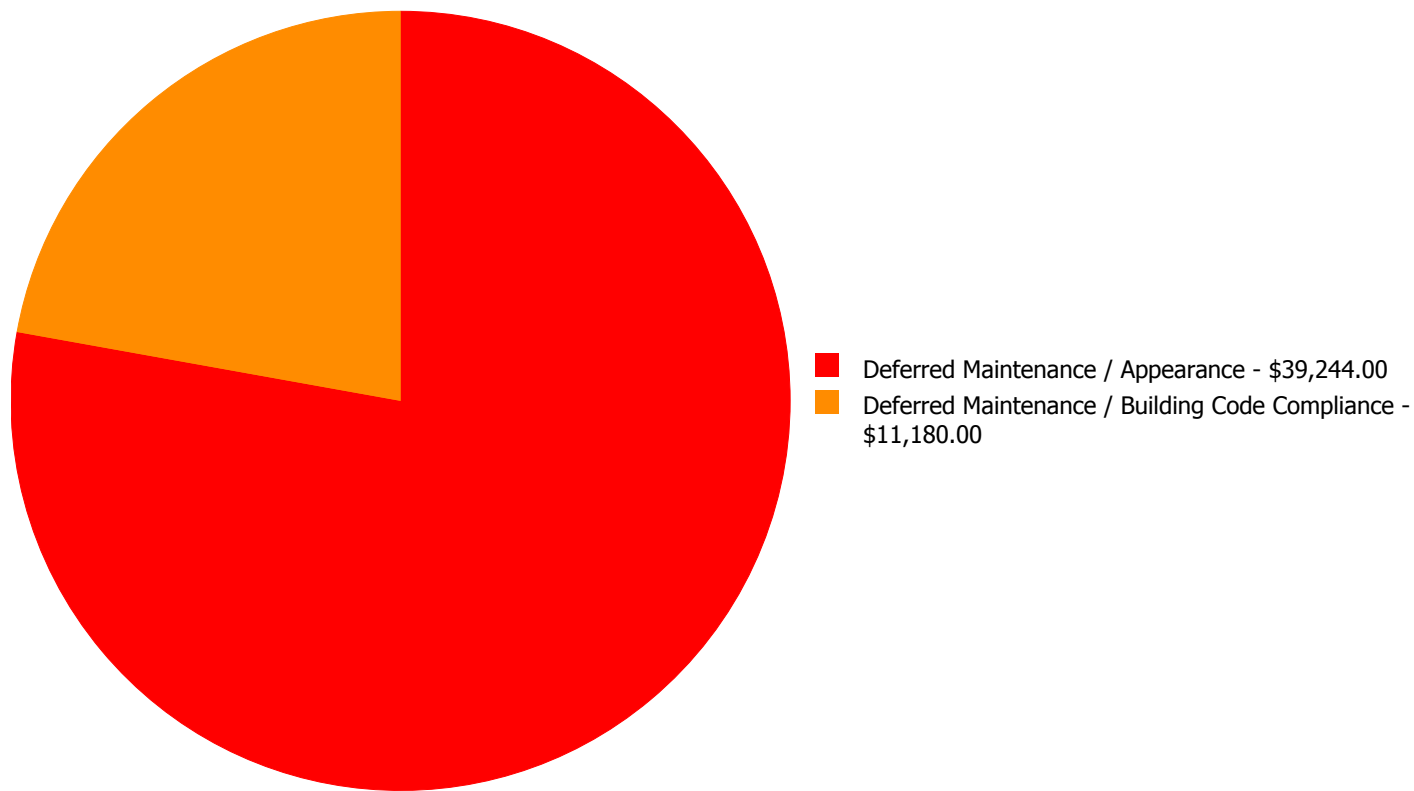
### Deficiency Summary by Category

The following chart shows the total repair costs broken down by deficiency categories. Assessors assigned deficiencies to one of the following categories:

**Budget Estimate Total: \$50,424.00**
