NC School District/995 Yancey County/High School

# Mountain Heritage High

## Campus Assessment Report

March 7, 2017

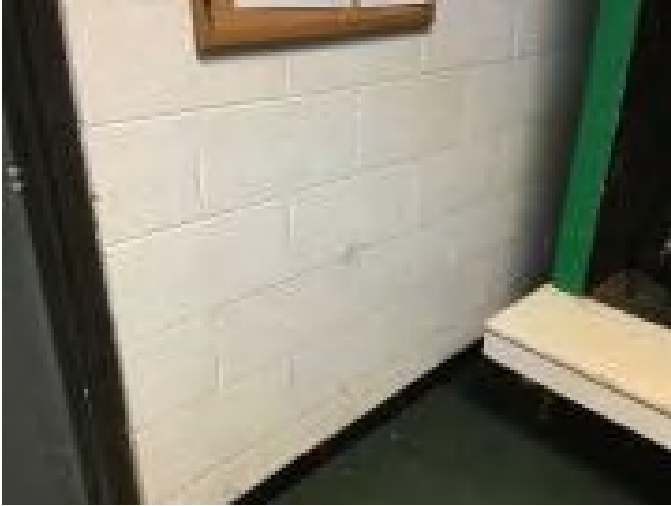
#### System: C3010 - Wall Finishes

**Location:** Throughout  
**Distress:** Beyond Service Life  
**Category:** Deferred Maintenance / Appearance  
**Priority:** 3 - Necessary/Not Yet Critical (Years 2-5)  
**Correction:** Renew System  
**Qty:** 1,200.00  
**Unit of Measure:** S.F.  
**Estimate:** \$9,847.00  
**Assessor Name:** Eduardo Lopez  
**Date Created:** 01/25/2017

**Notes:** The wall paint is damaged, fading, stained, and should be re-painted.

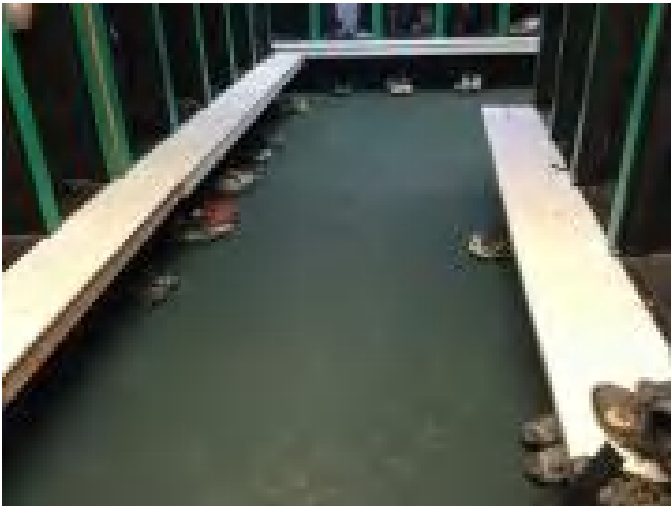
#### System: C3020 - Floor Finishes

**Location:** Locker rooms  
**Distress:** Beyond Service Life  
**Category:** Deferred Maintenance / Appearance  
**Priority:** 3 - Necessary/Not Yet Critical (Years 2-5)  
**Correction:** Renew System  
**Qty:** 1,200.00  
**Unit of Measure:** S.F.  
**Estimate:** \$16,817.00  
**Assessor Name:** Eduardo Lopez  
**Date Created:** 01/25/2017

**Notes:** The carpet is aged, stained, frayed, and should be replaced.

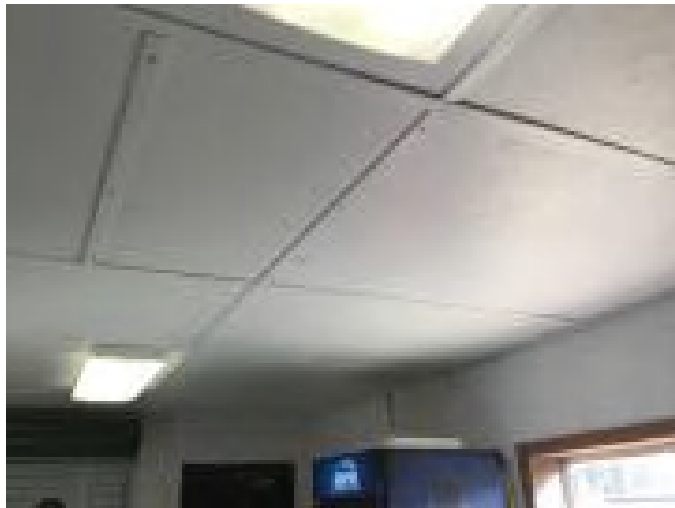
**System: C3030 - Ceiling Finishes**

**Location:** Throughout  
**Distress:** Beyond Service Life  
**Category:** Deferred Maintenance / Appearance  
**Priority:** 3 - Necessary/Not Yet Critical (Years 2-5)  
**Correction:** Renew System  
**Qty:** 1,200.00  
**Unit of Measure:** S.F.  
**Estimate:** \$12,580.00  
**Assessor Name:** Eduardo Lopez  
**Date Created:** 01/25/2017

**Notes:** The original ceiling finishes are aged, failing and should be replaced.

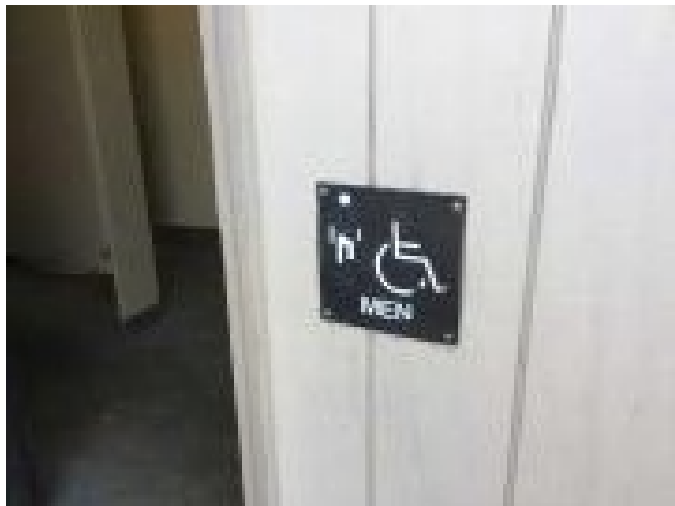
**System: C1030 - Fittings**

**Location:** Throughout  
**Distress:** Inadequate  
**Category:** Deferred Maintenance / Building Code Compliance  
**Priority:** 4 - Recommended (Years 6-10)  
**Correction:** Renew System  
**Qty:** 1,200.00  
**Unit of Measure:** S.F.  
**Estimate:** \$11,180.00  
**Assessor Name:** Eduardo Lopez  
**Date Created:** 01/25/2017

**Notes:** The fittings throughout the building are aged, in marginal condition, handrails and room signage are ADA non-compliance and system should be replaced.

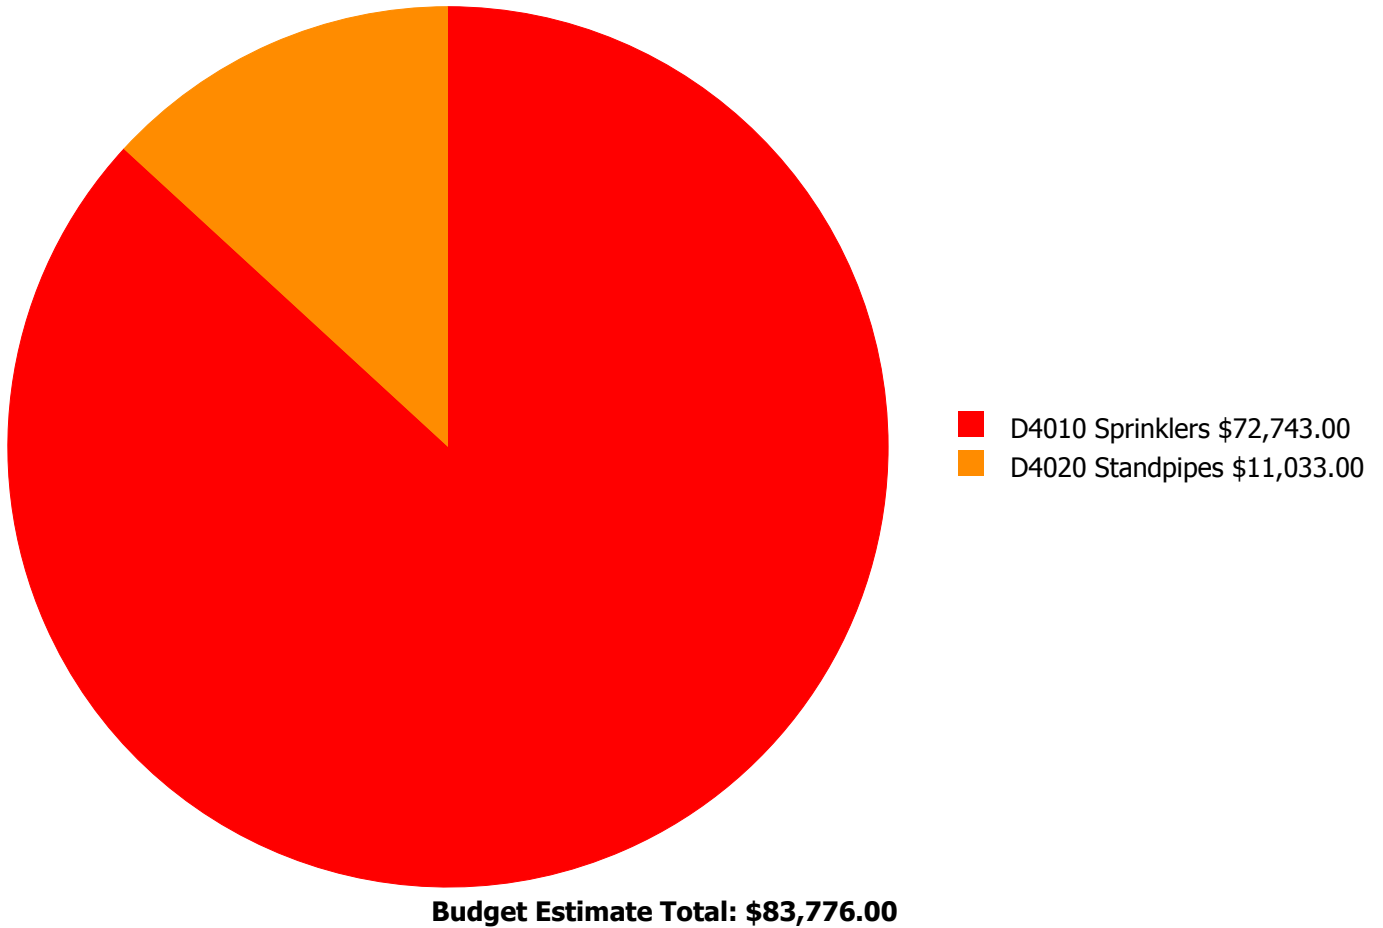
## Deficiency Summary by System

Current deficiencies included assemblies that have reached or exceeded their design life or components of the assemblies that are in need of repair. Assemblies that have reached their design life are identified as current deficiencies and assigned the distress 'Beyond Useful Life'. The following chart lists all current deficiencies associated with this facility.

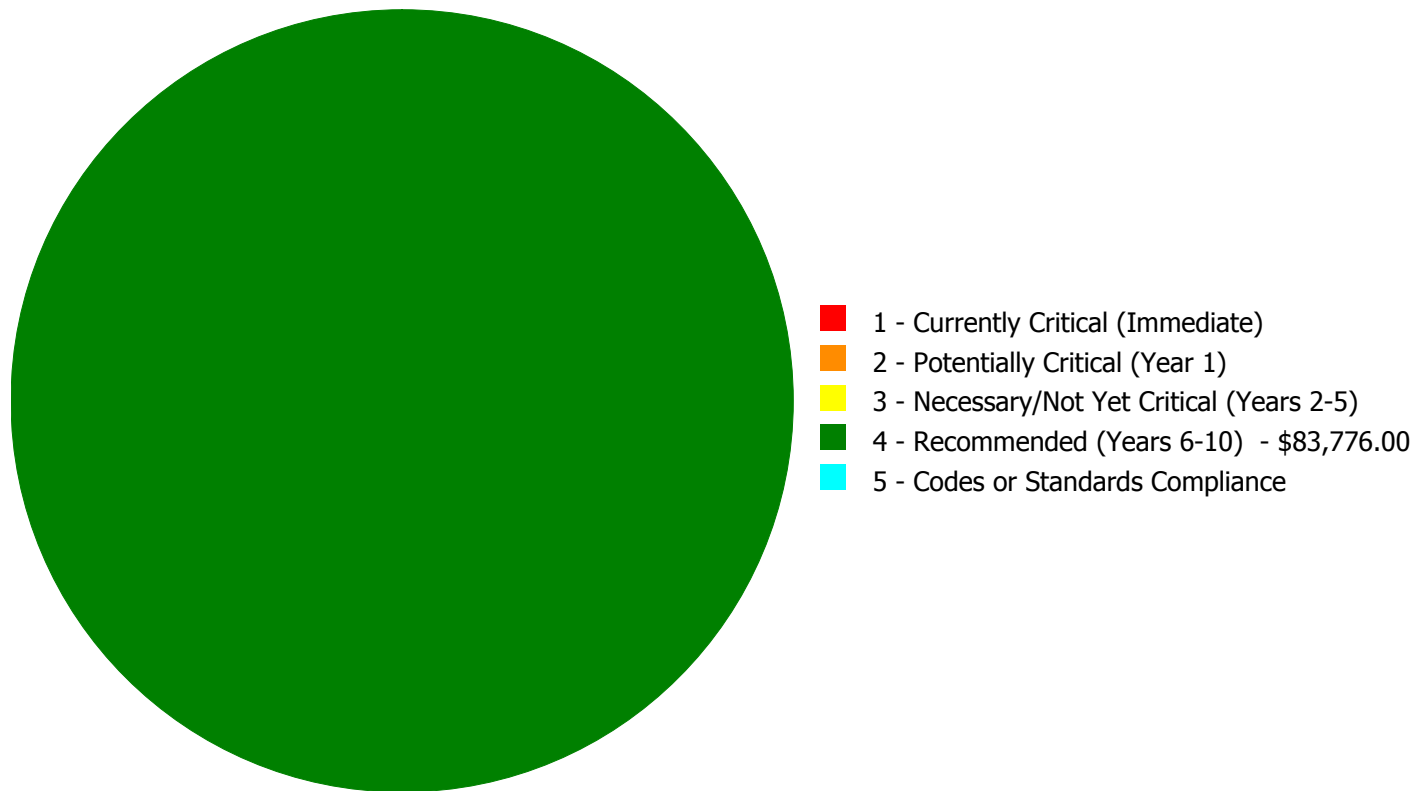
## Deficiency Summary by Priority

The following chart shows the total repair costs broken down by priority. Assessors assigned deficiencies within eCOMET to one of the following priority categories:

**Budget Estimate Total: \$83,776.00**

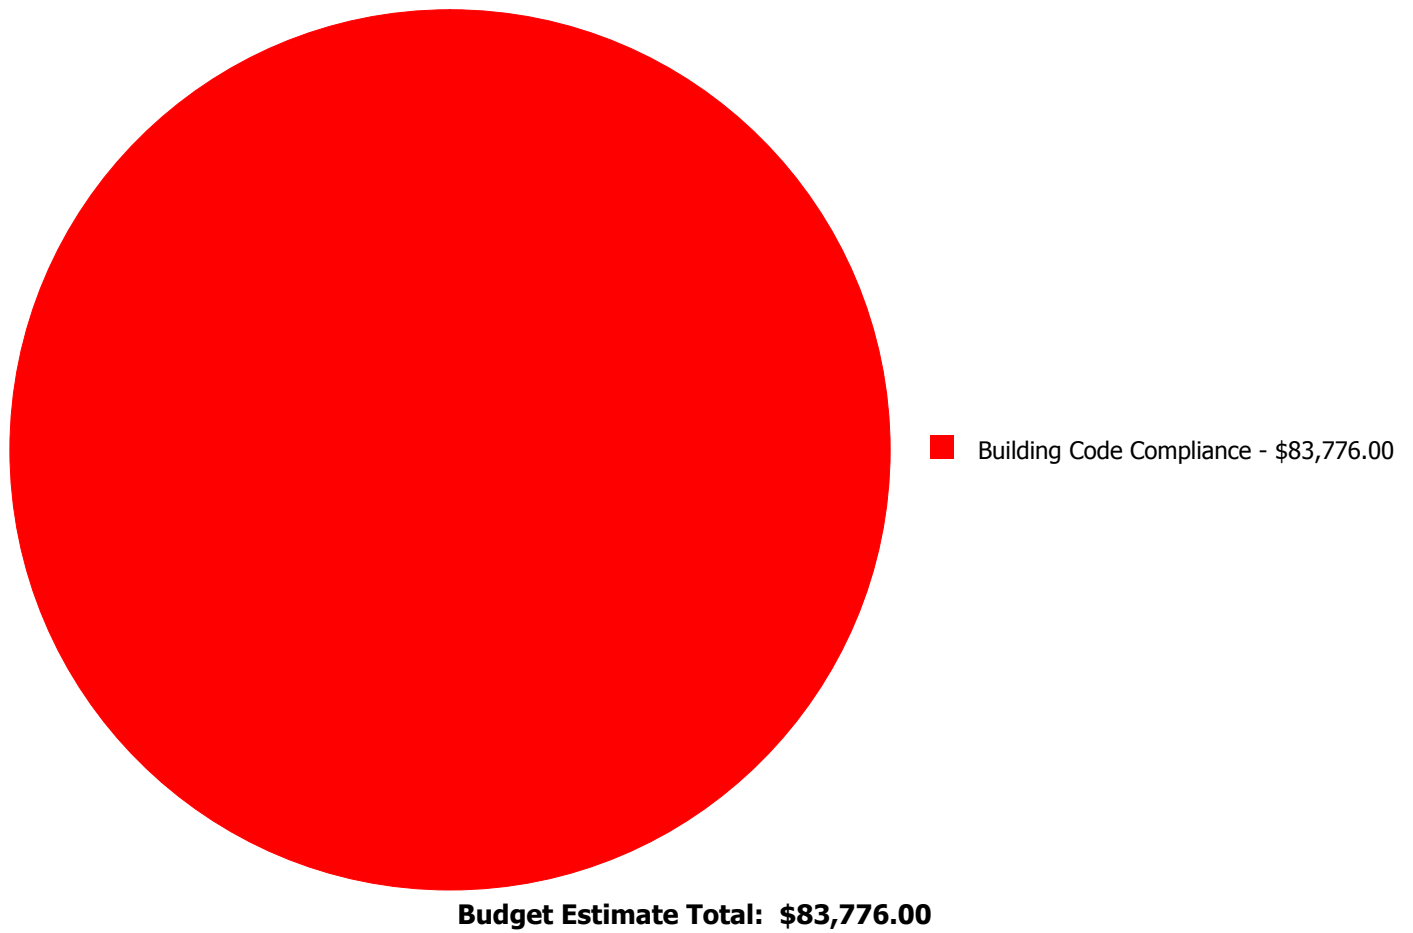
## Deficiency Summary by Category

The following chart shows the total repair costs broken down by deficiency categories. Assessors assigned deficiencies to one of the following categories:

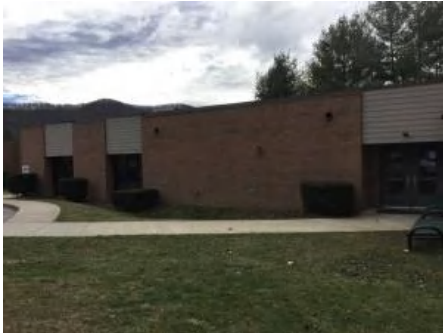
1). North Elevation - Feb 01, 2017

The photo album consists of the various cardinal directions of the building..

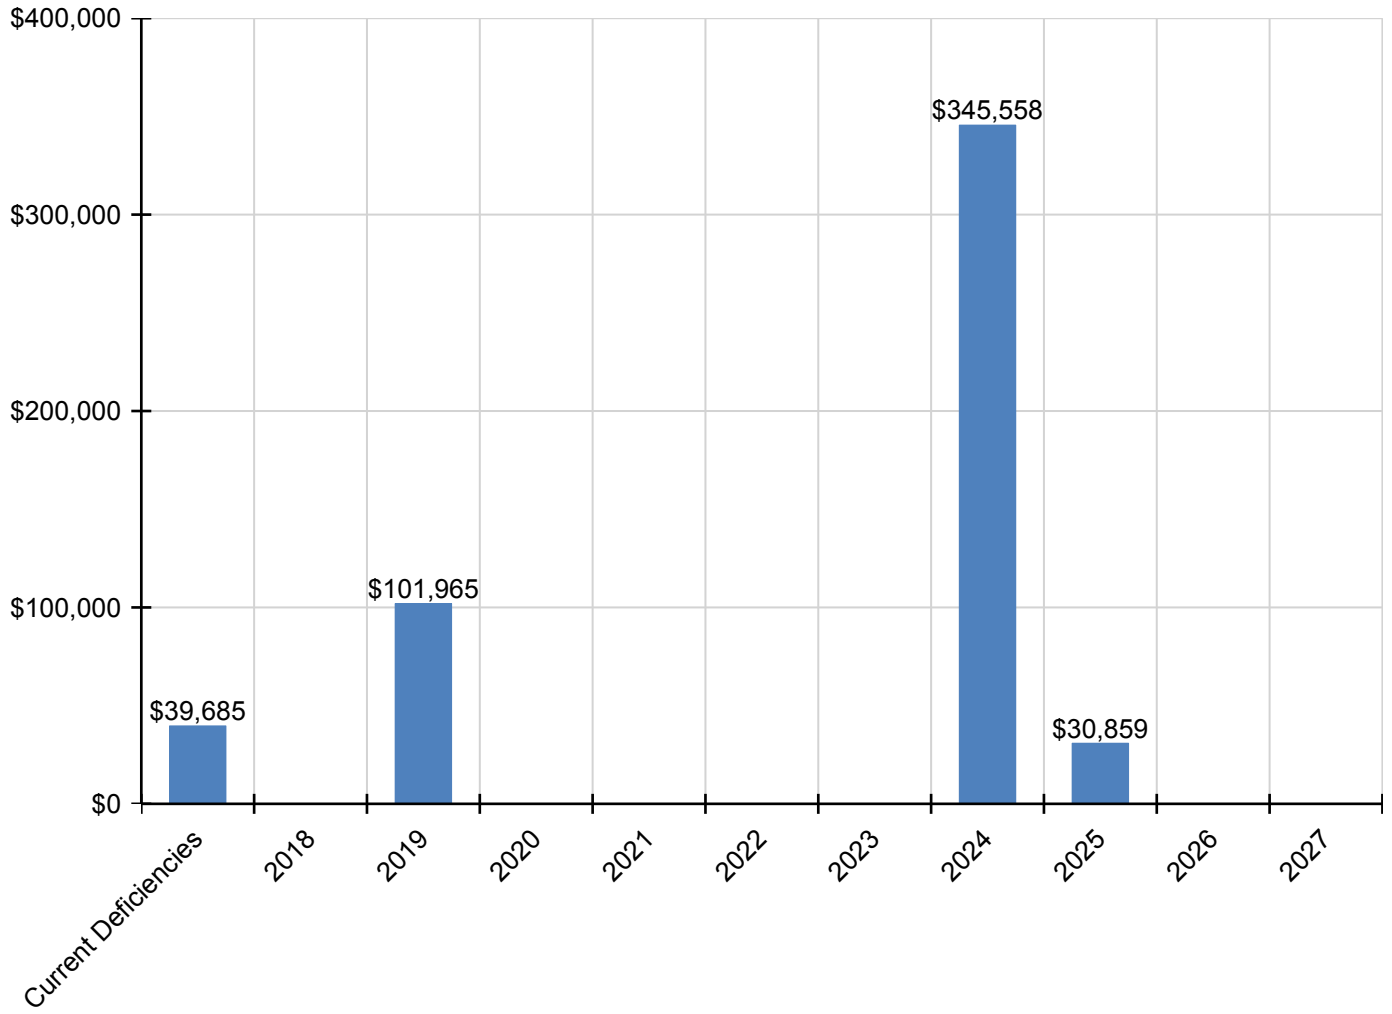
## Forecasted Capital Renewal Requirement

The following chart shows the current building deficiencies and forecasting capital renewal or sustainment requirements over the next ten years.

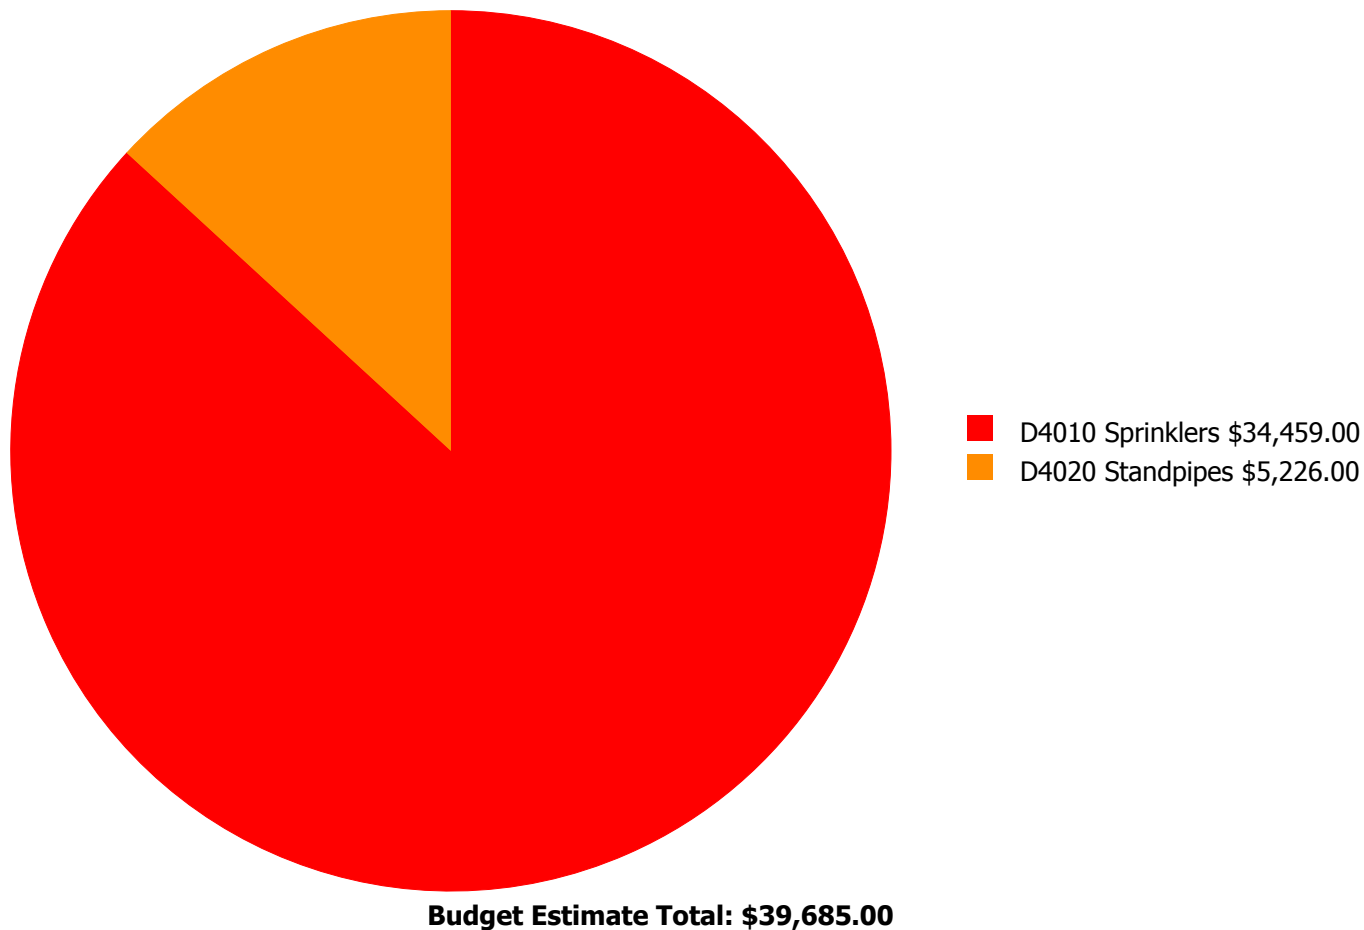
## Deficiency Summary by System

Current deficiencies included assemblies that have reached or exceeded their design life or components of the assemblies that are in need of repair. Assemblies that have reached their design life are identified as current deficiencies and assigned the distress 'Beyond Useful Life'. The following chart lists all current deficiencies associated with this facility.

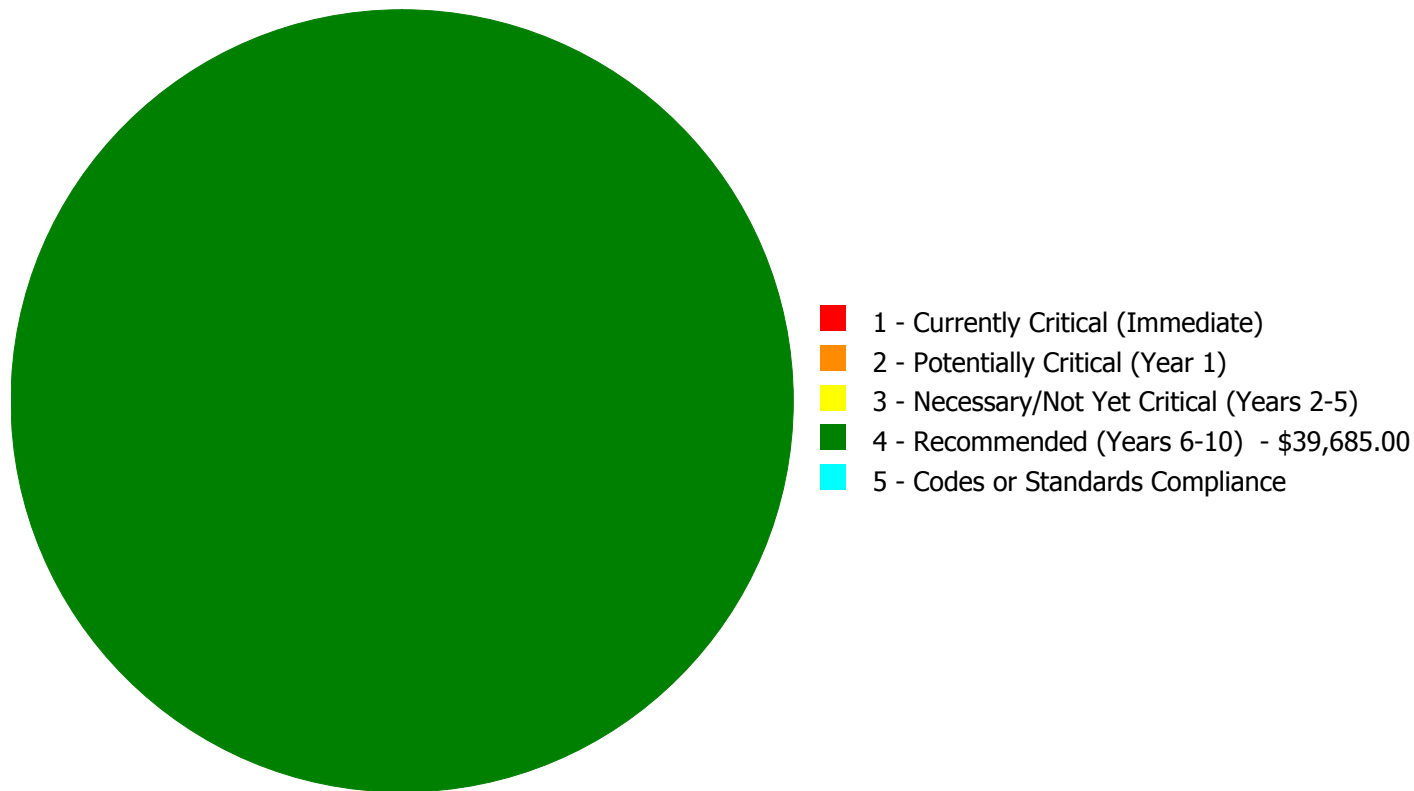
## Deficiency Summary by Priority

The following chart shows the total repair costs broken down by priority. Assessors assigned deficiencies within eCOMET to one of the following priority categories:

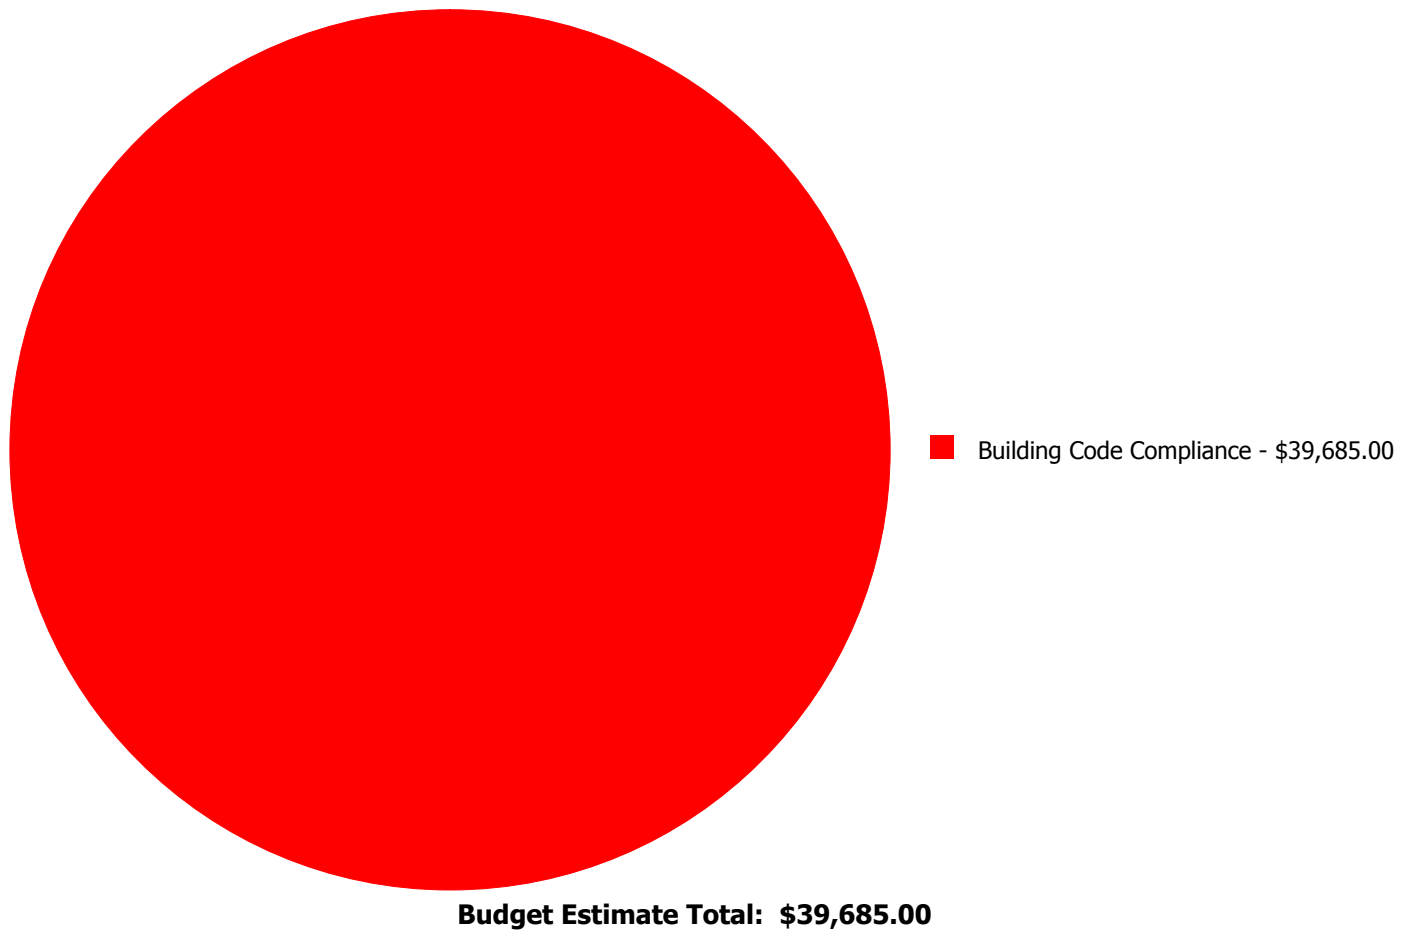
## Deficiency Summary by Category

The following chart shows the total repair costs broken down by deficiency categories. Assessors assigned deficiencies to one of the following categories:

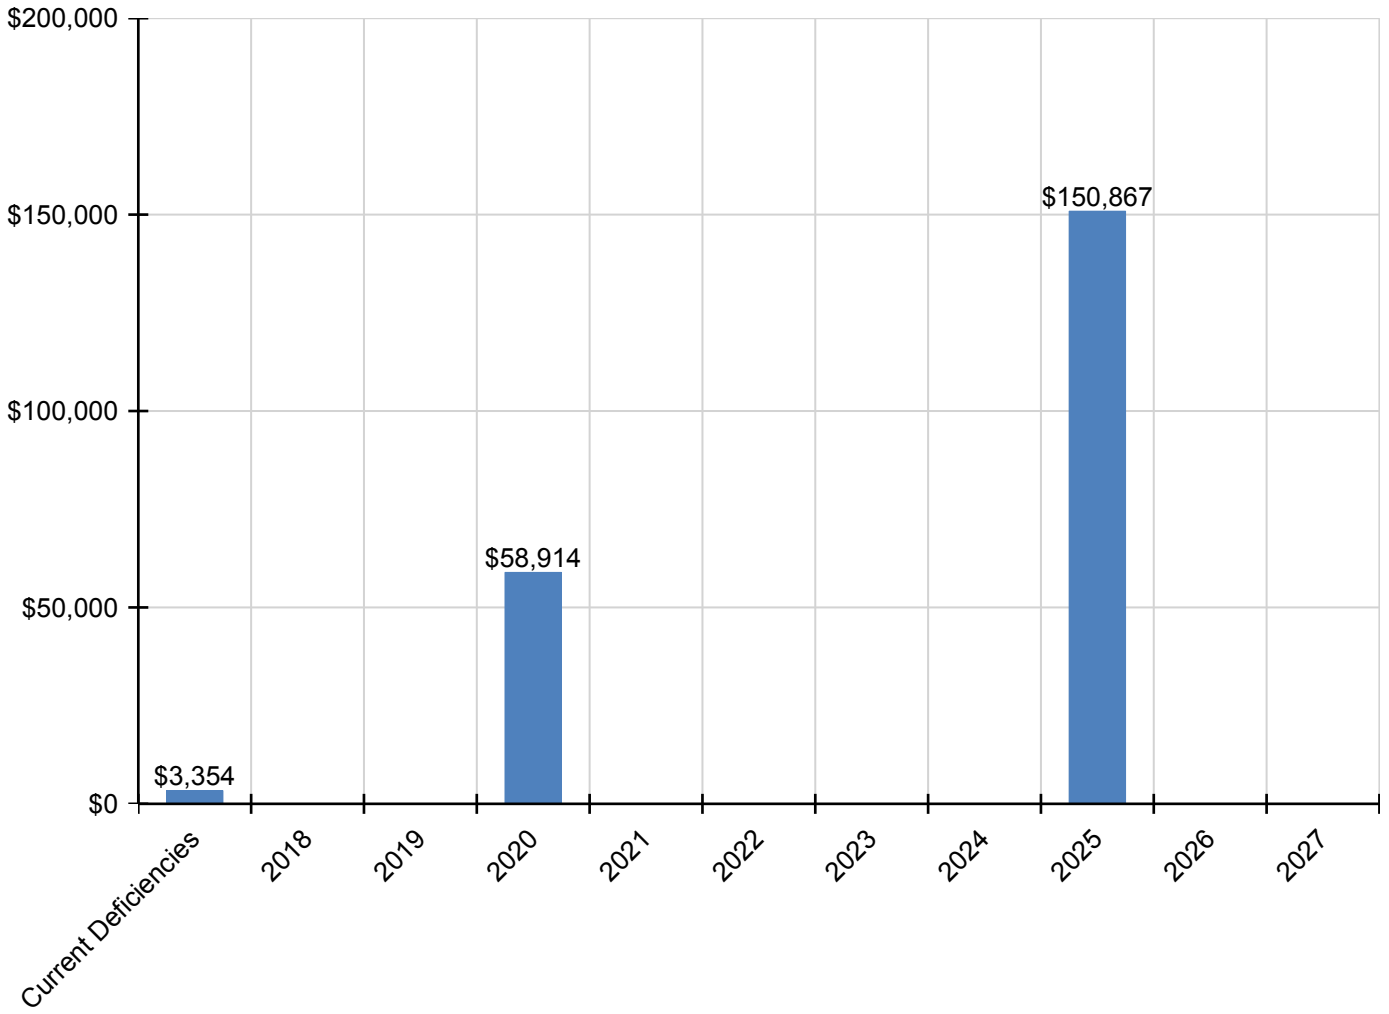
## Forecasted Capital Renewal Requirement

The following chart shows the current building deficiencies and forecasting capital renewal or sustainment requirements over the next ten years.

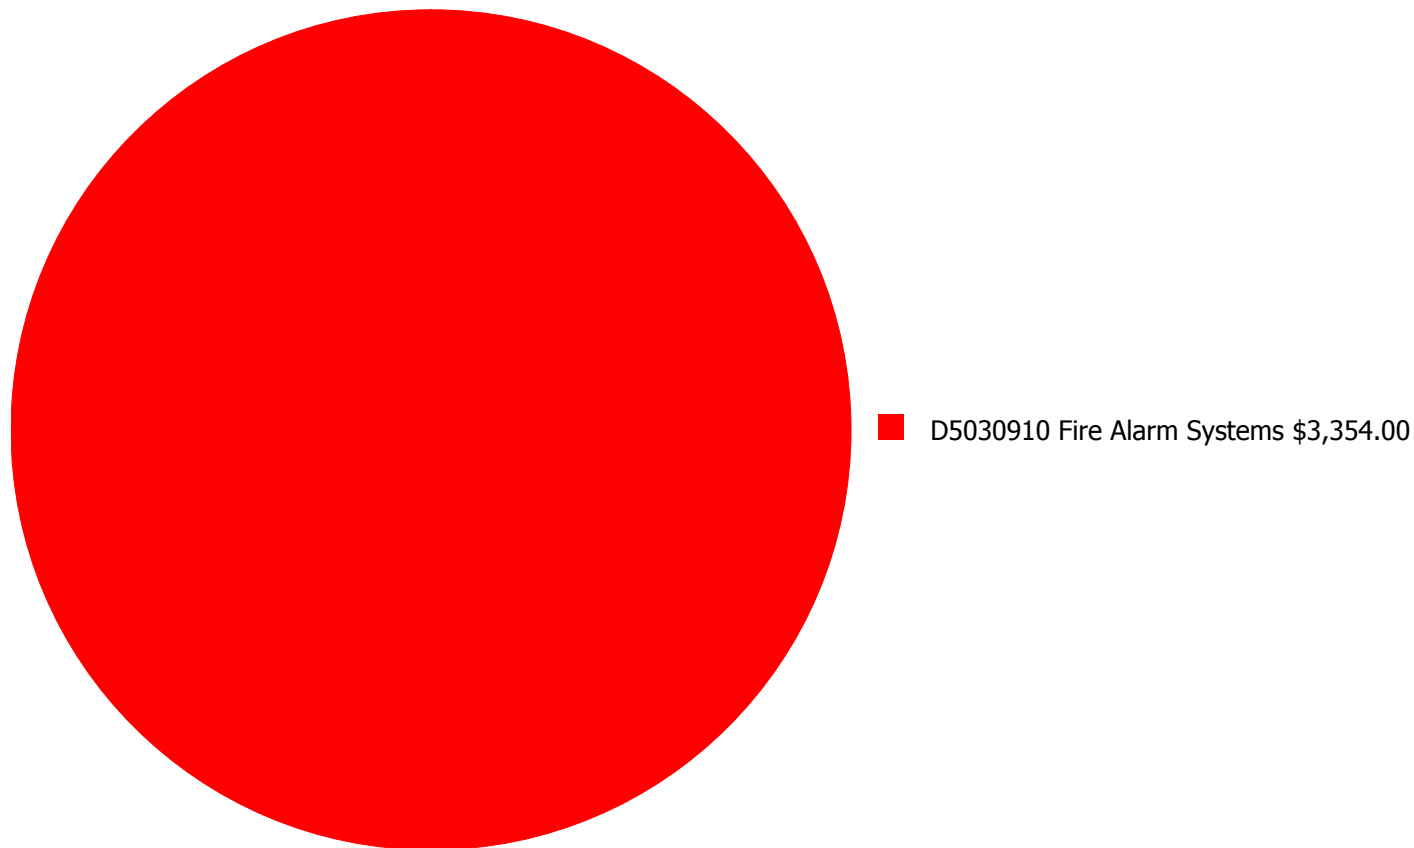
## Deficiency Summary by System

Current deficiencies included assemblies that have reached or exceeded their design life or components of the assemblies that are in need of repair. Assemblies that have reached their design life are identified as current deficiencies and assigned the distress 'Beyond Useful Life'. The following chart lists all current deficiencies associated with this facility.

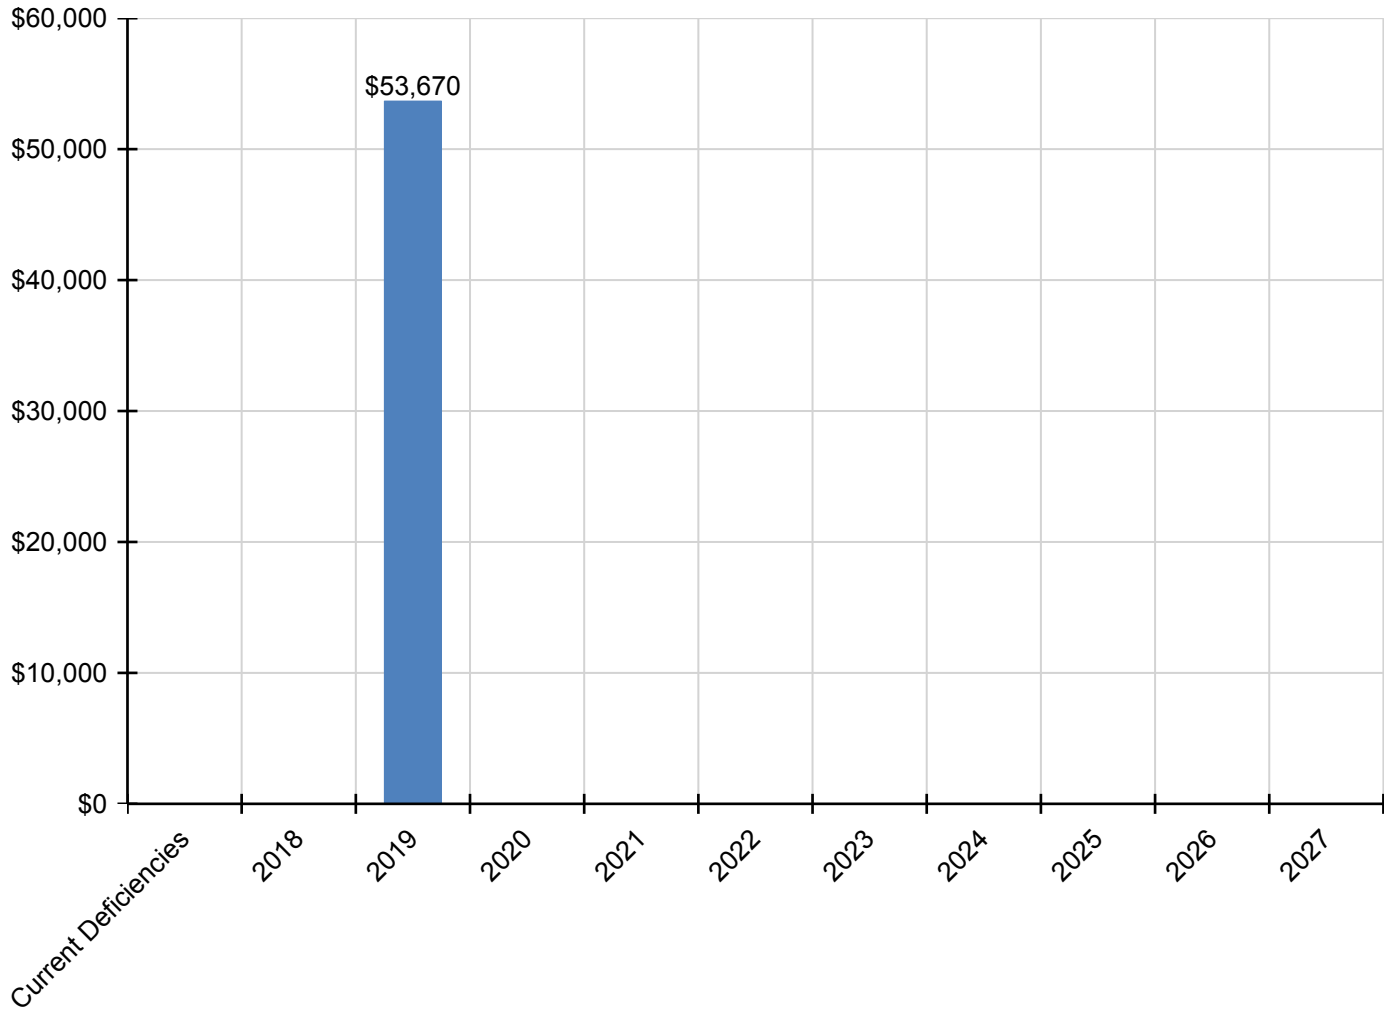
## Forecasted Capital Renewal Requirement

The following chart shows the current building deficiencies and forecasting capital renewal or sustainment requirements over the next ten years.

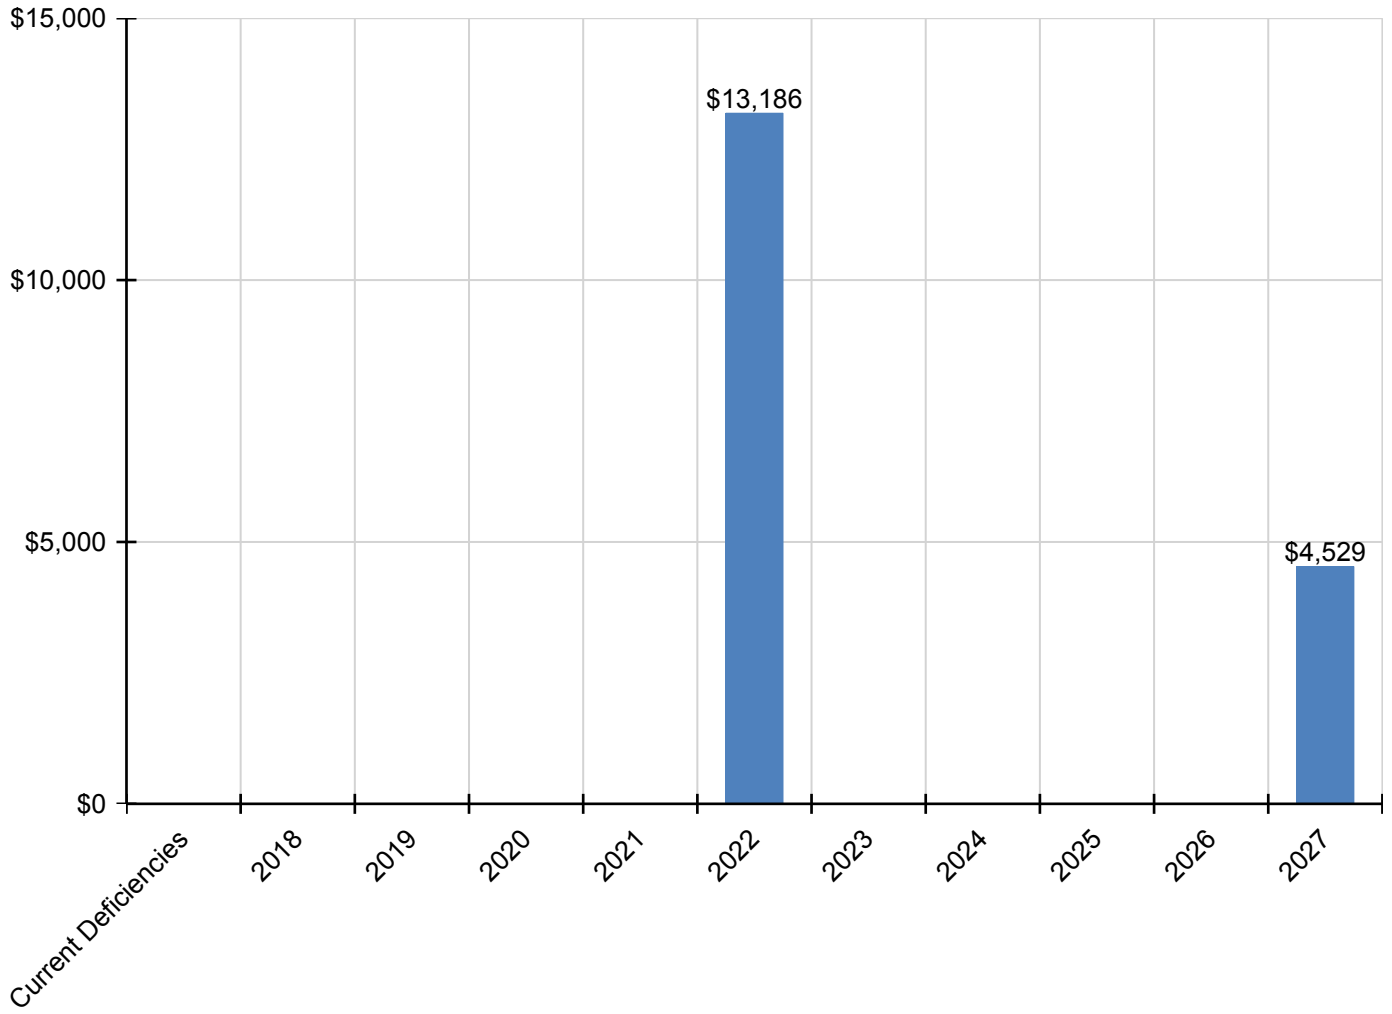
## Forecasted Capital Renewal Requirement

The following chart shows the current building deficiencies and forecasting capital renewal or sustainment requirements over the next ten years.

eCOMET forecasts future Capital Renewal projects for expiring systems based on the Calculated Next Renewal year found in the system listing. There is a 3% yearly inflation factor applied to the system costs expiring in the future. The table below reflects Capital Renewal projects over the next 10 years. Note: Blank cells (or \$0) indicate no systems are scheduled for renewal in that year.

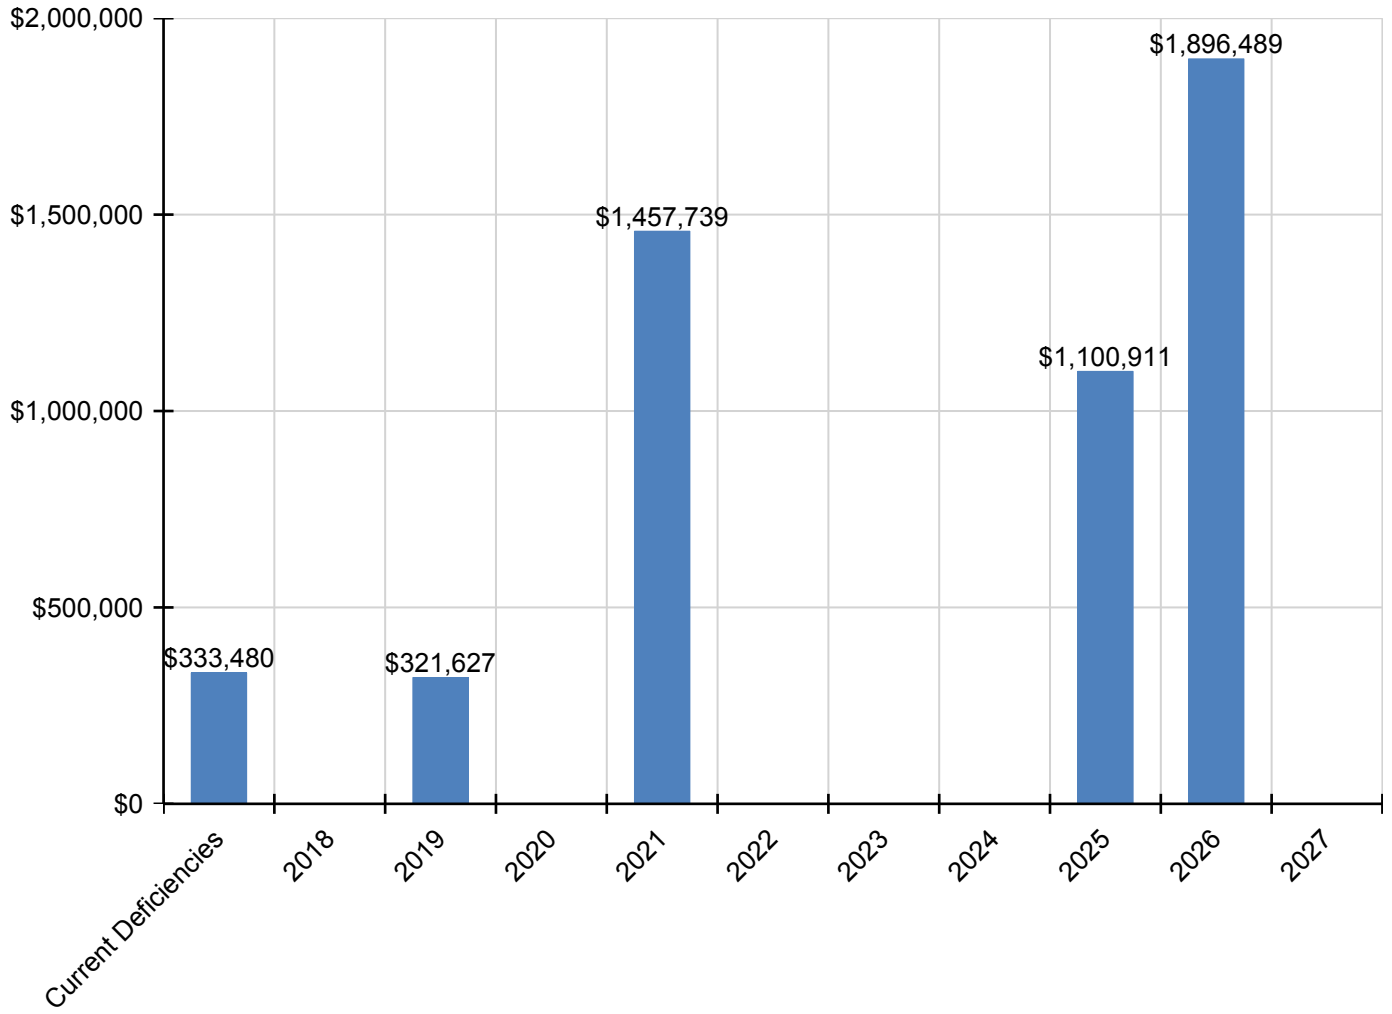
## Forecasted Capital Renewal Requirement

The following chart shows the current building deficiencies and forecasting capital renewal or sustainment requirements over the next ten years.

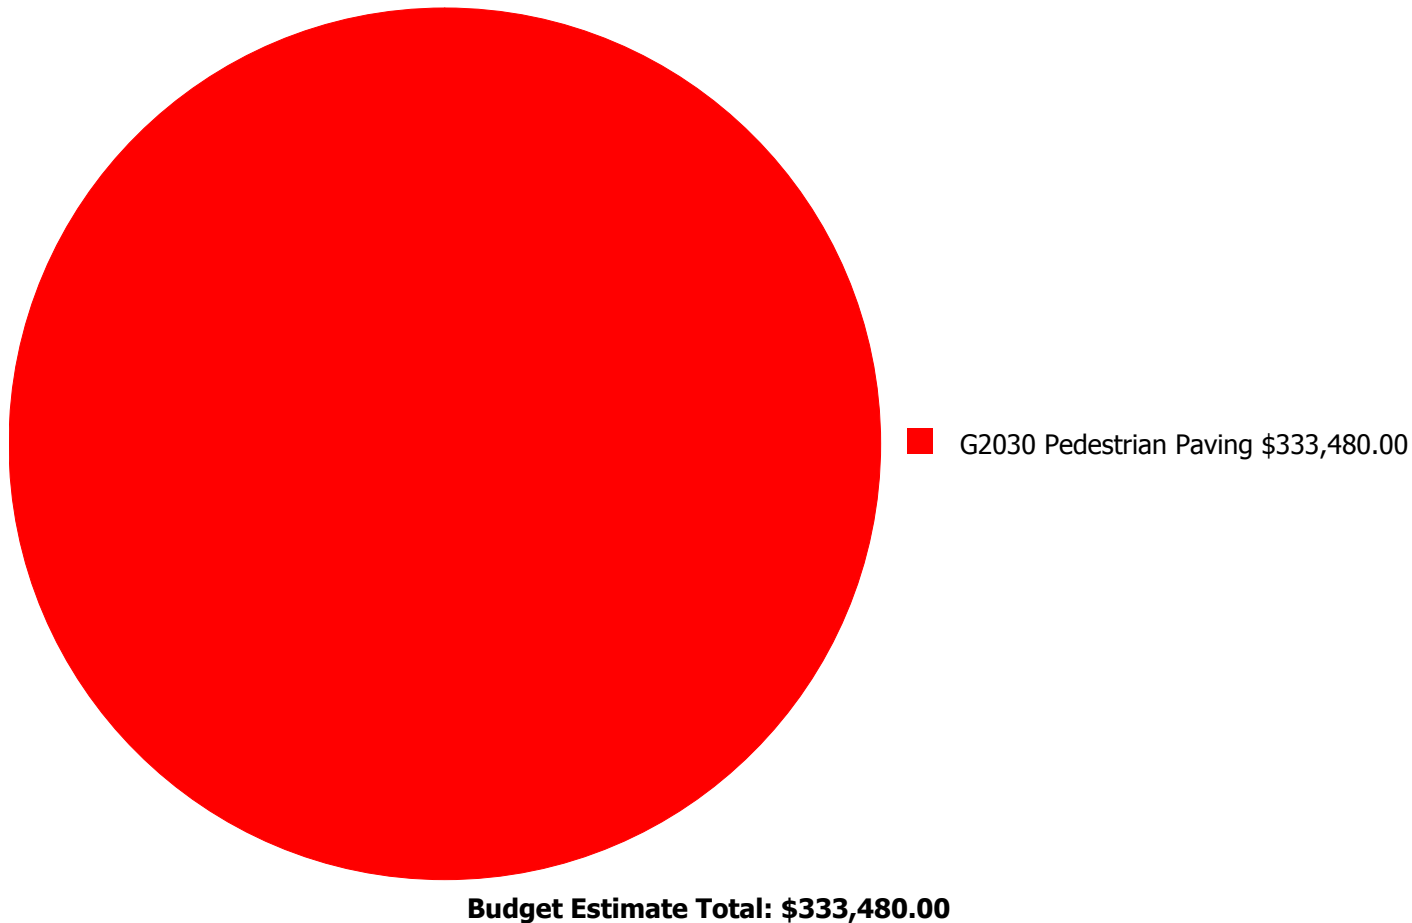
## Deficiency Summary by System

Current deficiencies included assemblies that have reached or exceeded their design life or components of the assemblies that are in need of repair. Assemblies that have reached their design life are identified as current deficiencies and assigned the distress 'Beyond Useful Life'. The following chart lists all current deficiencies associated with this facility.

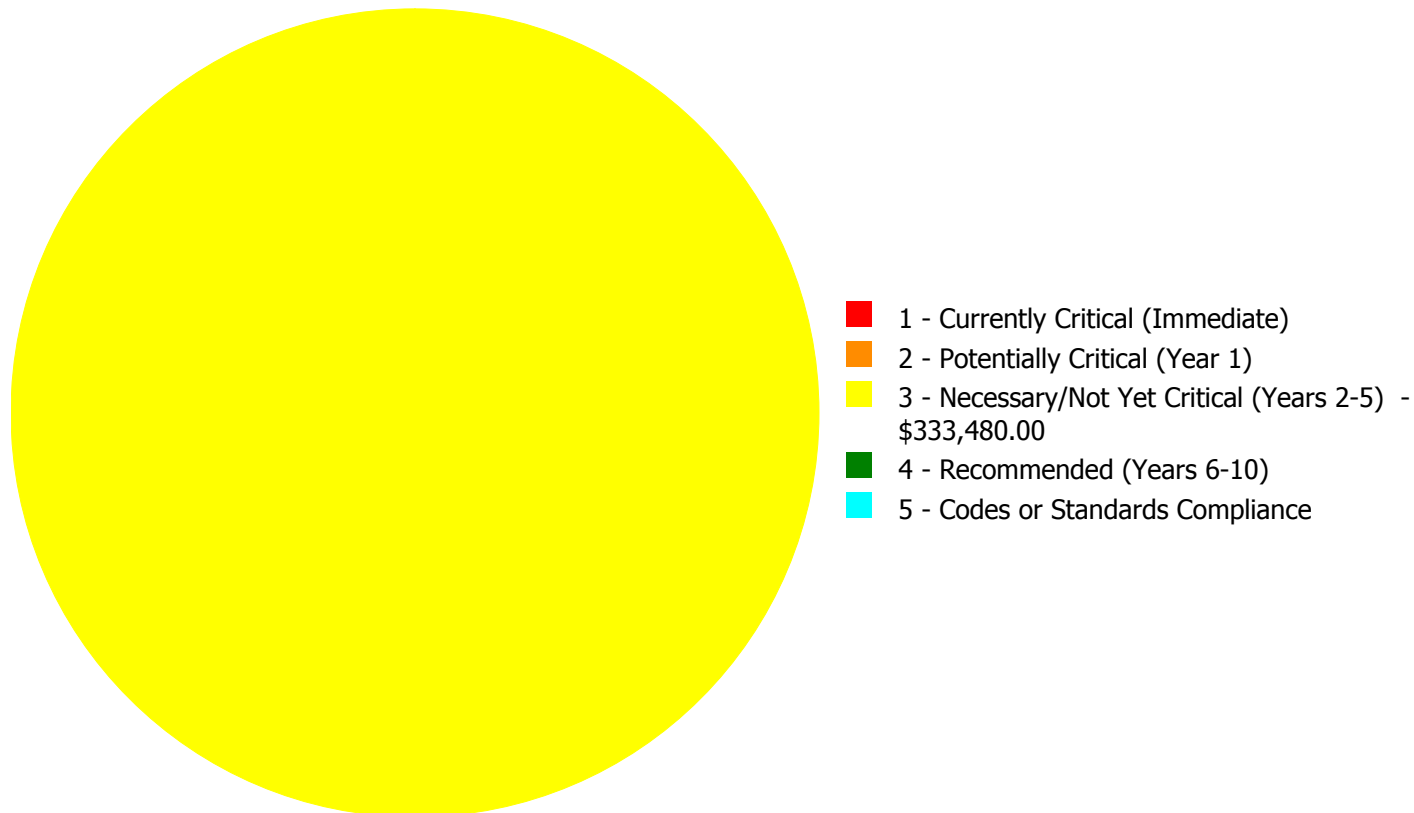
## Deficiency Summary by Priority

The following chart shows the total repair costs broken down by priority. Assessors assigned deficiencies within eCOMET to one of the following priority categories:

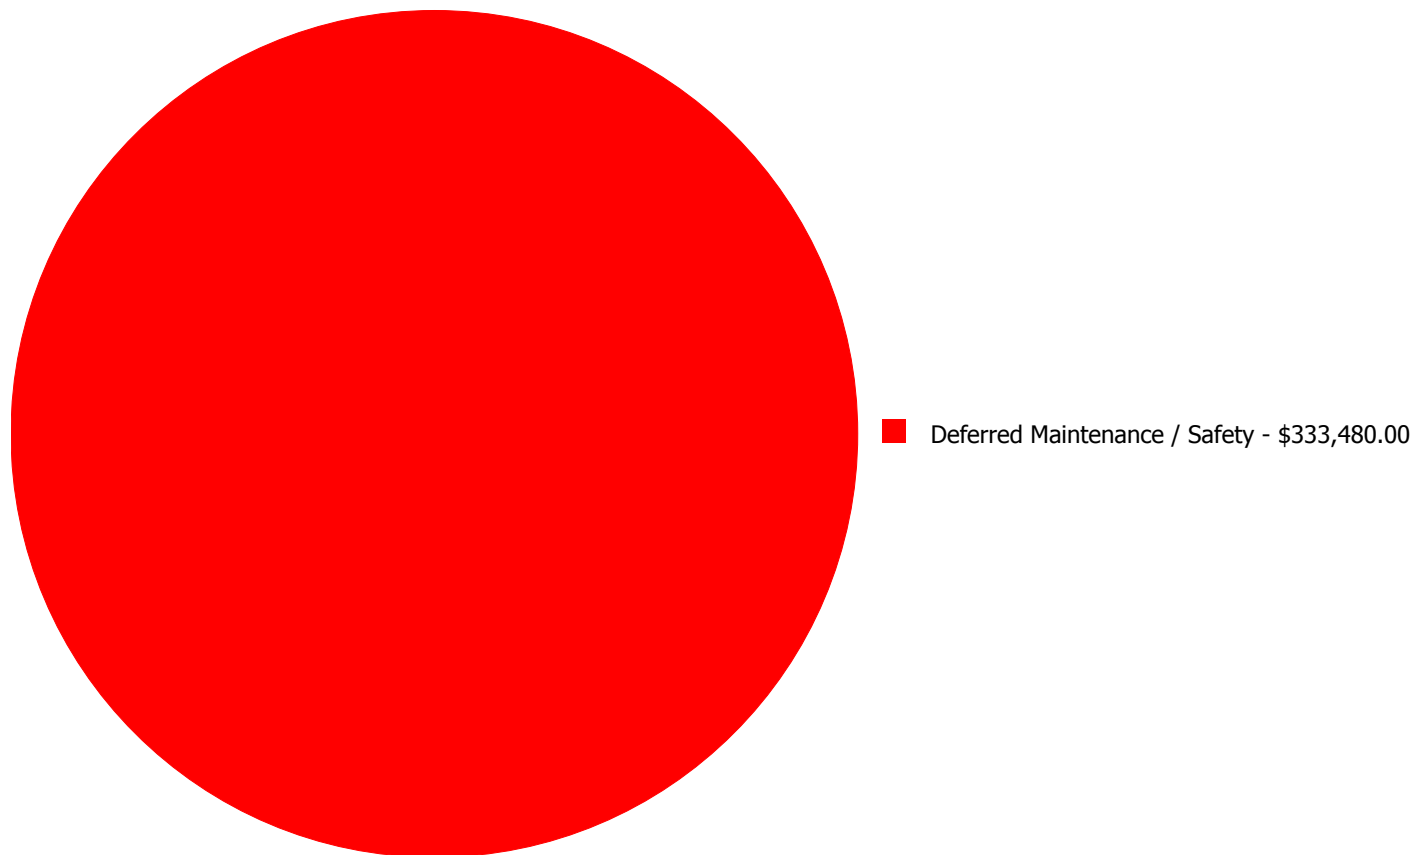
## Deficiency Summary by Category

The following chart shows the total repair costs broken down by deficiency categories. Assessors assigned deficiencies to one of the following categories:

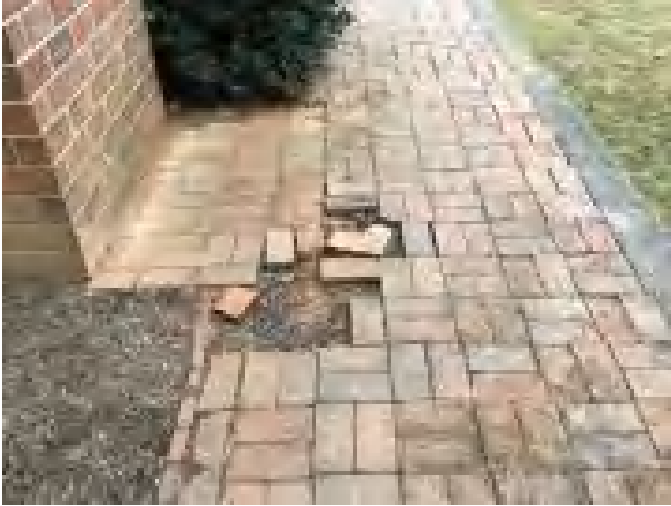
#### **System: G2030 - Pedestrian Paving**

**Location:** Multiple areas  
**Distress:** Failing  
**Category:** Deferred Maintenance / Safety  
**Priority:** 3 - Necessary/Not Yet Critical (Years 2-5)  
**Correction:** Renew System  
**Qty:** 153,113.00  
**Unit of Measure:** S.F.  
**Estimate:** \$333,480.00  
**Assessor Name:** Matt Mahaffey  
**Date Created:** 01/25/2017

**Notes:** The pedestrian paving and walkways are aged and showing inclement weather damage and should be replaced.
