NC School District/995 Yancey County/High School

# Mountain Heritage High

## Campus Assessment Report

March 7, 2017

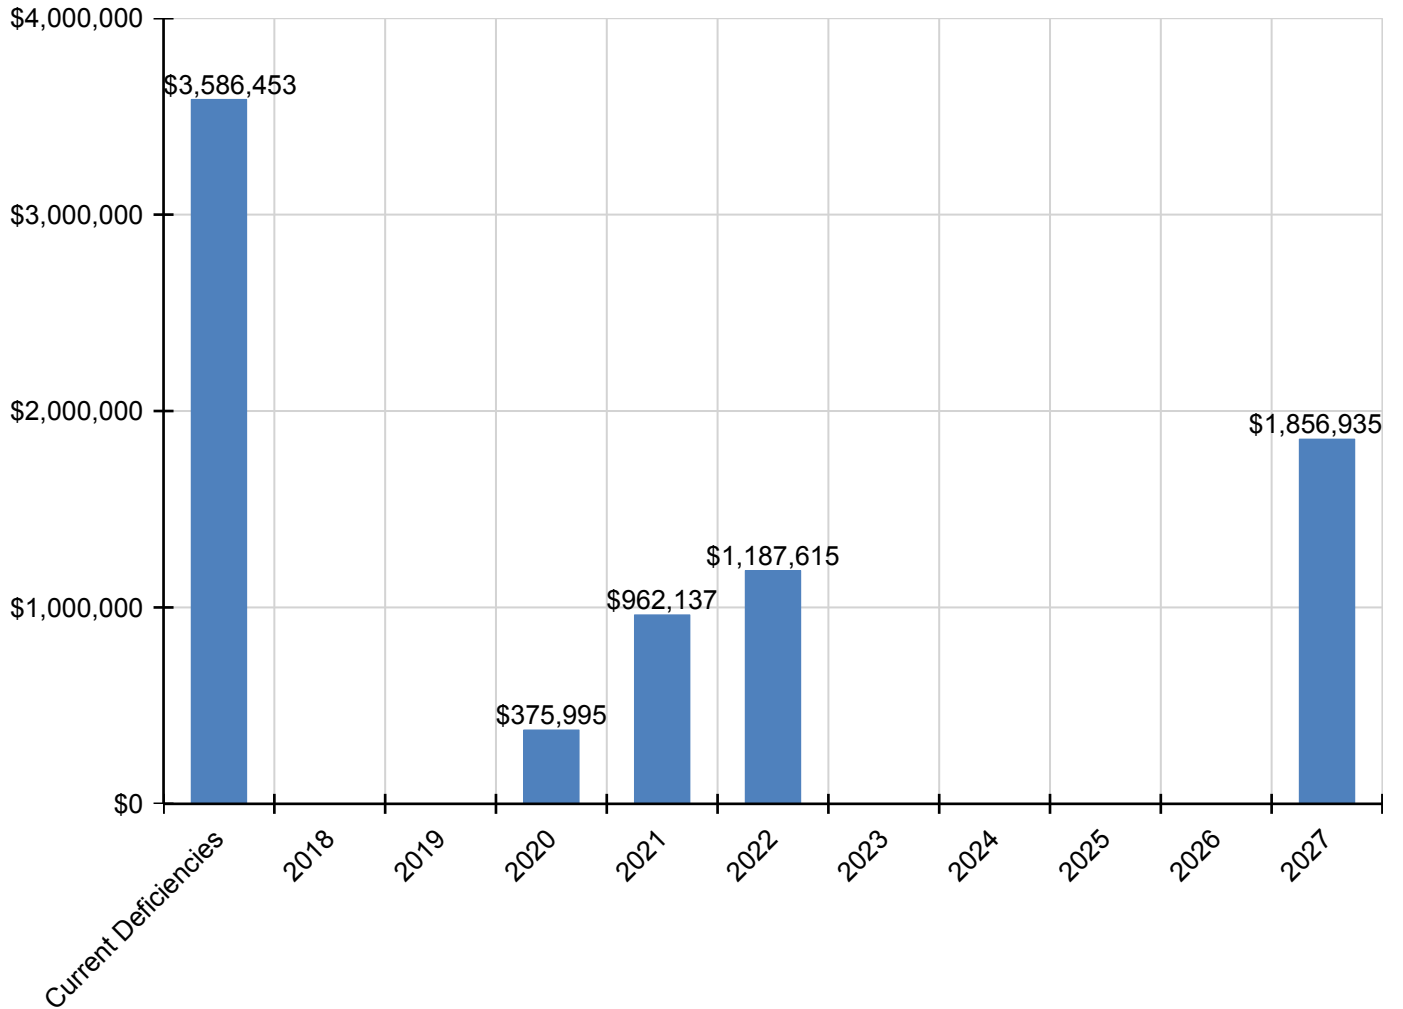
## Forecasted Capital Renewal Requirement

The following chart shows the current building deficiencies and forecasting capital renewal or sustainment requirements over the next ten years.

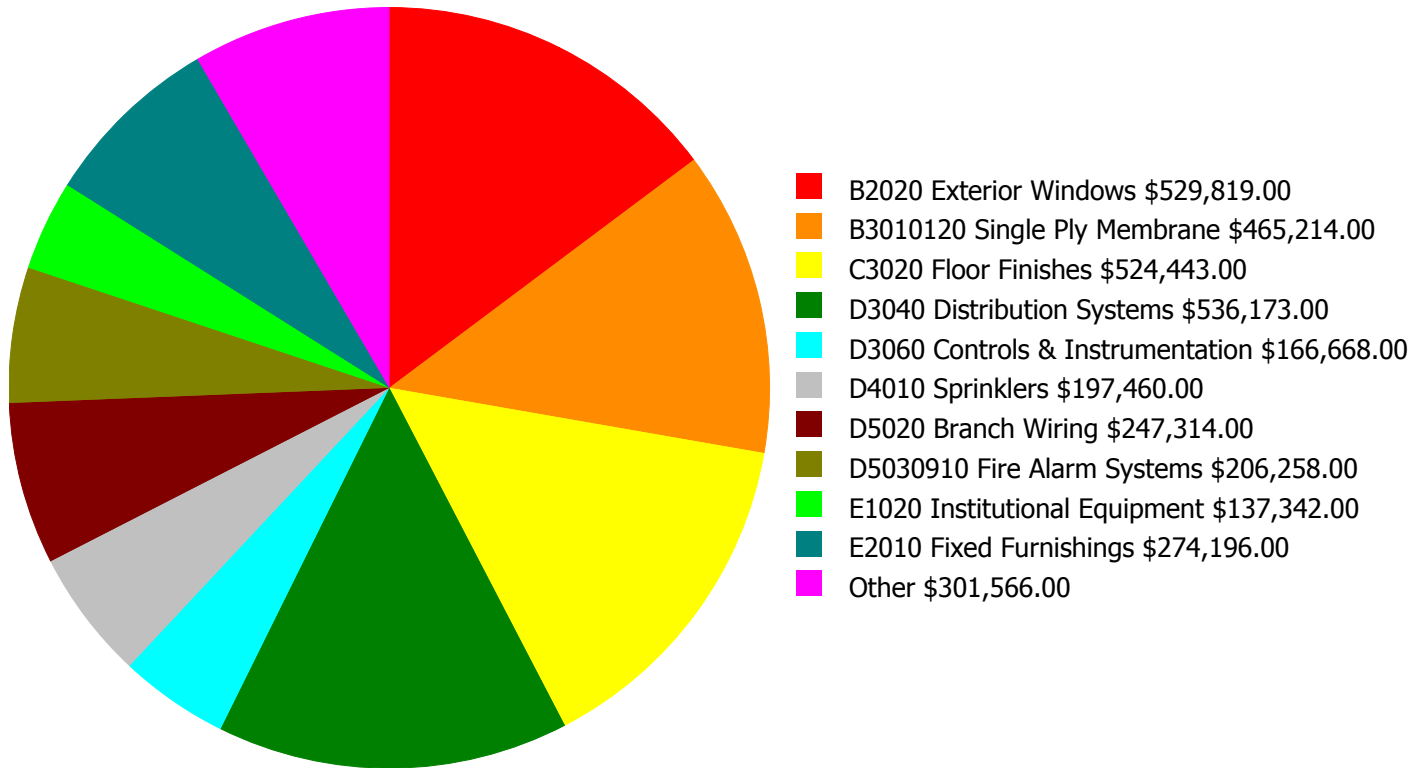
## Deficiency Summary by System

Current deficiencies included assemblies that have reached or exceeded their design life or components of the assemblies that are in need of repair. Assemblies that have reached their design life are identified as current deficiencies and assigned the distress 'Beyond Useful Life'. The following chart lists all current deficiencies associated with this facility.

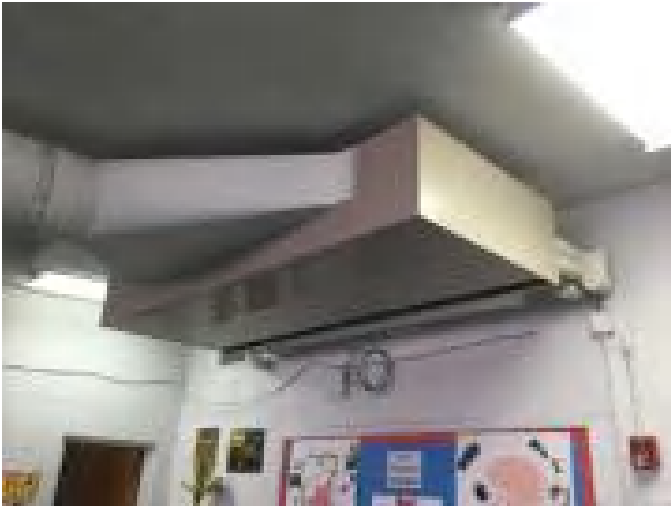
#### System: D3040 - Distribution Systems

**Location:** Throughout  
**Distress:** Failing  
**Category:** Deferred Maintenance / Energy  
**Priority:** 2 - Potentially Critical (Year 1)  
**Correction:** Renew System  
**Qty:** 44,433.00  
**Unit of Measure:** S.F.  
**Estimate:** \$536,173.00  
**Assessor Name:** Terence Davis  
**Date Created:** 02/01/2017

**Notes:** The air distribution system is aged, becoming logistically unsupportable, and should be replaced.

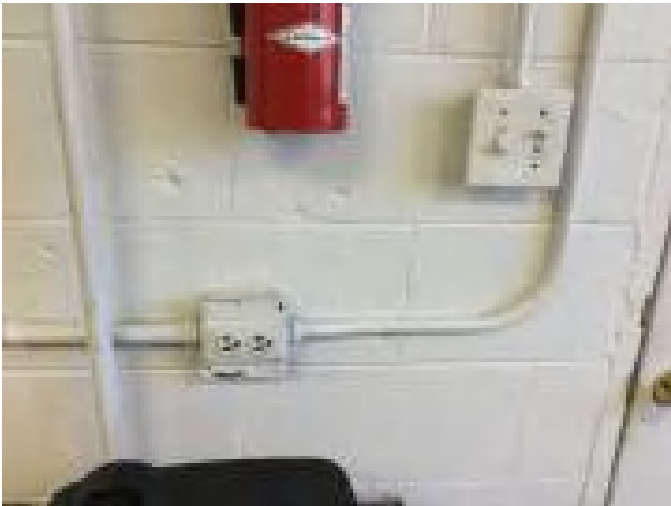
#### System: D5020 - Branch Wiring

**Location:** Throughout  
**Distress:** Beyond Service Life  
**Category:** Deferred Maintenance / Safety  
**Priority:** 2 - Potentially Critical (Year 1)  
**Correction:** Renew System  
**Qty:** 44,433.00  
**Unit of Measure:** S.F.  
**Estimate:** \$247,314.00  
**Assessor Name:** Terence Davis  
**Date Created:** 02/01/2017

**Notes:** The original branch wiring system is operating, but is aged, in poor condition, and should be replaced.

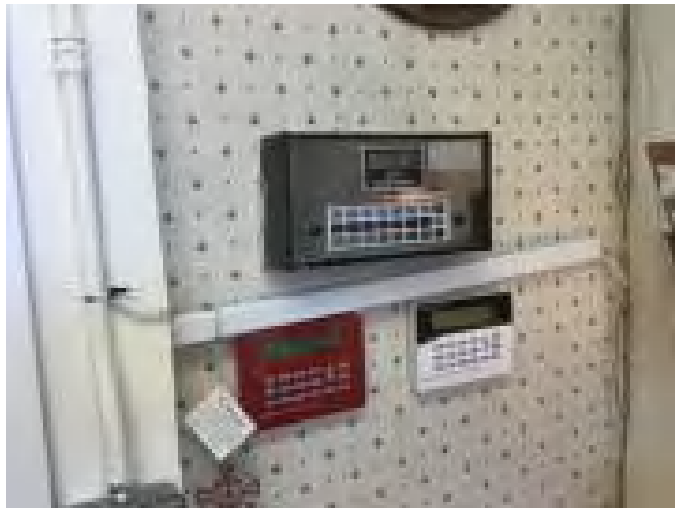
**System: D5030910 - Fire Alarm Systems**

**Location:** Office  
**Distress:** Beyond Service Life  
**Category:** Deferred Maintenance / Building Code Compliance  
**Priority:** 2 - Potentially Critical (Year 1)  
**Correction:** Renew System  
**Qty:** 44,433.00  
**Unit of Measure:** S.F.  
**Estimate:** \$206,258.00  
**Assessor Name:** Terence Davis  
**Date Created:** 02/01/2017

**Notes:** Fire alarm system is aged and should be upgraded to conform with current building code.

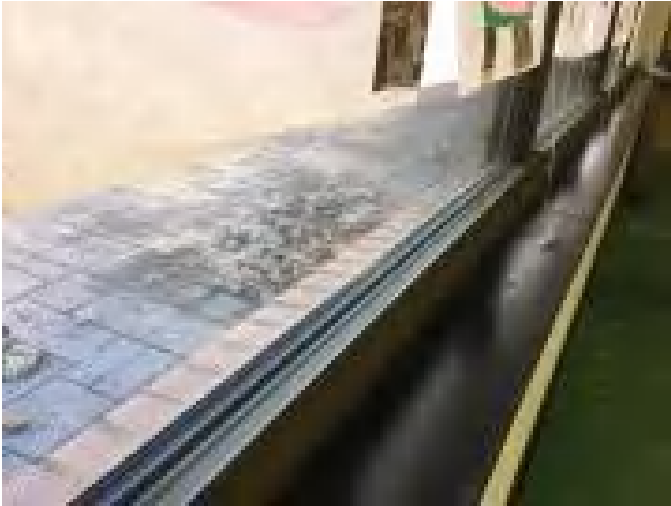
**System: B2020 - Exterior Windows**

**Location:** Throughout  
**Distress:** Beyond Service Life  
**Category:** Deferred Maintenance / Energy  
**Priority:** 3 - Necessary/Not Yet Critical (Years 2-5)  
**Correction:** Renew System  
**Qty:** 44,433.00  
**Unit of Measure:** S.F.  
**Estimate:** \$529,819.00  
**Assessor Name:** Terence Davis  
**Date Created:** 02/01/2017

**Notes:** The aluminum frame, operable, windows are aged, rusted, not energy efficient, and should be replaced.

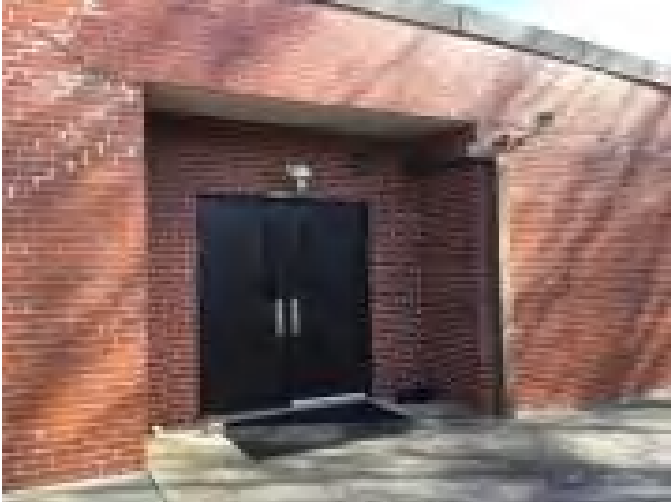
**System: B2030 - Exterior Doors**

**Location:** Throughout  
**Distress:** Beyond Service Life  
**Category:** Deferred Maintenance / Appearance  
**Priority:** 3 - Necessary/Not Yet Critical (Years 2-5)  
**Correction:** Renew System  
**Qty:** 44,433.00  
**Unit of Measure:** S.F.  
**Estimate:** \$50,831.00  
**Assessor Name:** Terence Davis  
**Date Created:** 02/01/2017

**Notes:** The original exterior doors are aged, rusted, and should be replaced.

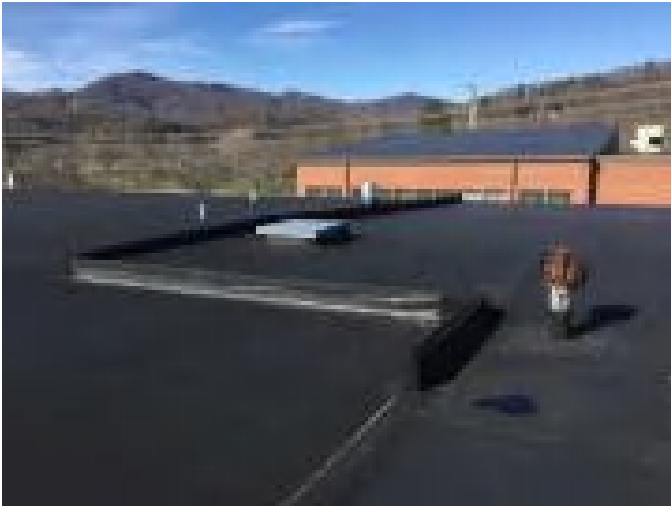
**System: B3010120 - Single Ply Membrane**

**Location:** Throughout  
**Distress:** Beyond Service Life  
**Category:** Deferred Maintenance  
**Priority:** 3 - Necessary/Not Yet Critical (Years 2-5)  
**Correction:** Renew System  
**Qty:** 44,433.00  
**Unit of Measure:** S.F.  
**Estimate:** \$465,214.00  
**Assessor Name:** Terence Davis  
**Date Created:** 02/01/2017

**Notes:** The EPDM adhered roof coverings are aging, showing signs of failure and should be replaced.

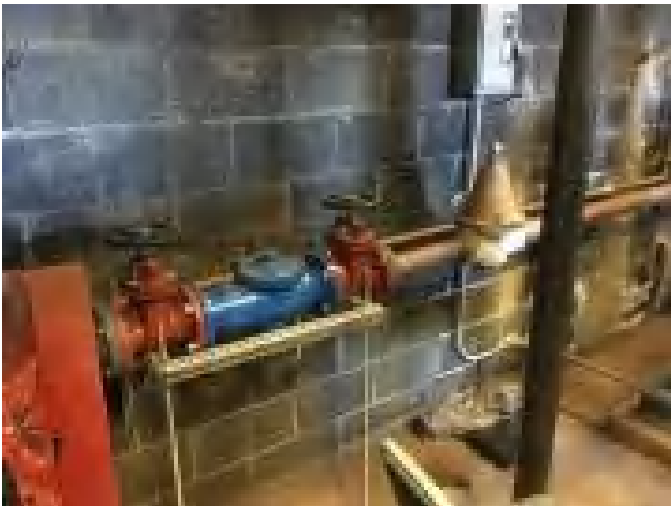
**System: D2020 - Domestic Water Distribution**

**Location:** Throughout  
**Distress:** Beyond Service Life  
**Category:** Deferred Maintenance / Building Code Compliance  
**Priority:** 3 - Necessary/Not Yet Critical (Years 2-5)  
**Correction:** Renew System  
**Qty:** 44,433.00  
**Unit of Measure:** S.F.  
**Estimate:** \$51,809.00  
**Assessor Name:** Terence Davis  
**Date Created:** 02/01/2017

**Notes:** The domestic water distribution system is aged, does not include a back-flow preventer, and should be replaced.

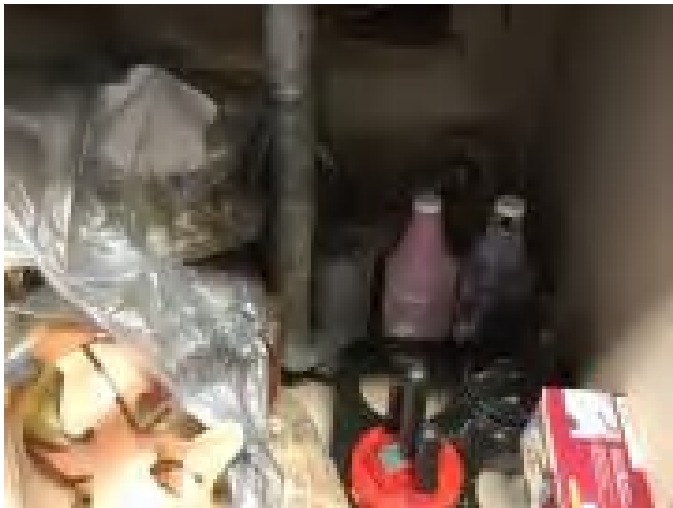
**System: D2030 - Sanitary Waste**

**Location:** Throughout  
**Distress:** Beyond Service Life  
**Category:** Deferred Maintenance  
**Priority:** 3 - Necessary/Not Yet Critical (Years 2-5)  
**Correction:** Renew System  
**Qty:** 44,433.00  
**Unit of Measure:** S.F.  
**Estimate:** \$82,112.00  
**Assessor Name:** Terence Davis  
**Date Created:** 02/01/2017

**Notes:** The sanitary waste system is aged, has reported periodic failures, and should be replaced.

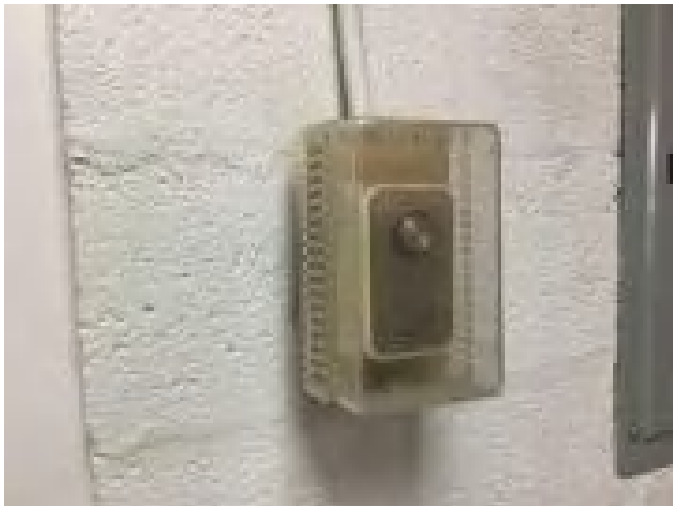
**System: D3060 - Controls & Instrumentation**

**Location:** Throughout  
**Distress:** Beyond Service Life  
**Category:** Deferred Maintenance / Energy  
**Priority:** 3 - Necessary/Not Yet Critical (Years 2-5)  
**Correction:** Renew System  
**Qty:** 44,433.00  
**Unit of Measure:** S.F.  
**Estimate:** \$166,668.00  
**Assessor Name:** Terence Davis  
**Date Created:** 02/01/2017

**Notes:** The HVAC controls system is aged, becoming logistically unsupportable, and should be replaced.

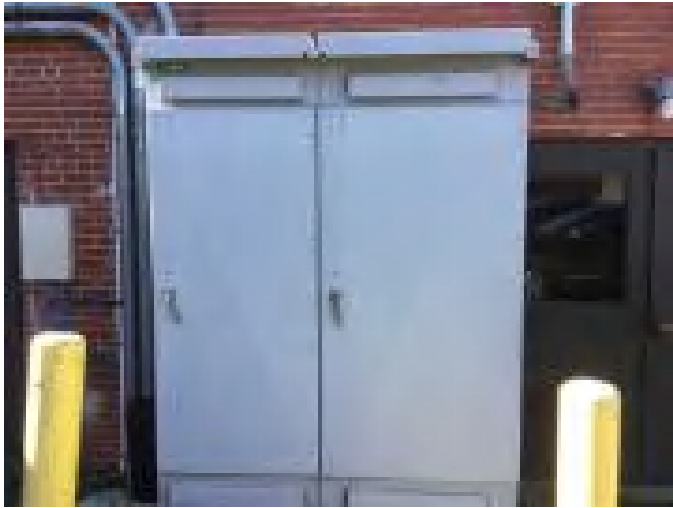
**System: D5010 - Electrical Service/Distribution**

**Location:** Throughout  
**Distress:** Beyond Service Life  
**Category:** Deferred Maintenance / Energy  
**Priority:** 3 - Necessary/Not Yet Critical (Years 2-5)  
**Correction:** Renew System  
**Qty:** 44,433.00  
**Unit of Measure:** S.F.  
**Estimate:** \$82,601.00  
**Assessor Name:** Terence Davis  
**Date Created:** 02/01/2017

**Notes:** The original electrical distribution system is operating properly due to an aggressive maintenance program but is aged, in marginal condition, and should be replaced.

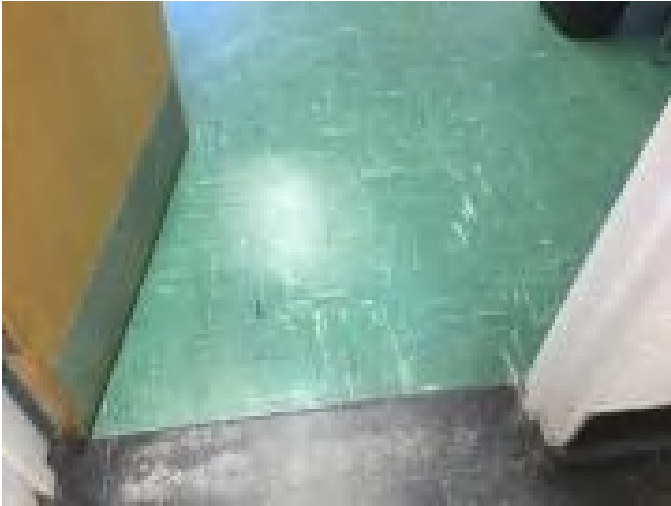
**System: C3020 - Floor Finishes**

**Location:** Throughout  
**Distress:** Beyond Service Life  
**Category:** Deferred Maintenance / Safety  
**Priority:** 4 - Recommended (Years 6-10)  
**Correction:** Renew System  
**Qty:** 44,433.00  
**Unit of Measure:** S.F.  
**Estimate:** \$524,443.00  
**Assessor Name:** Terence Davis  
**Date Created:** 02/01/2017

**Notes:** The VCT flooring is aged, cracked, worn, and should be replaced and ACM tile removed.

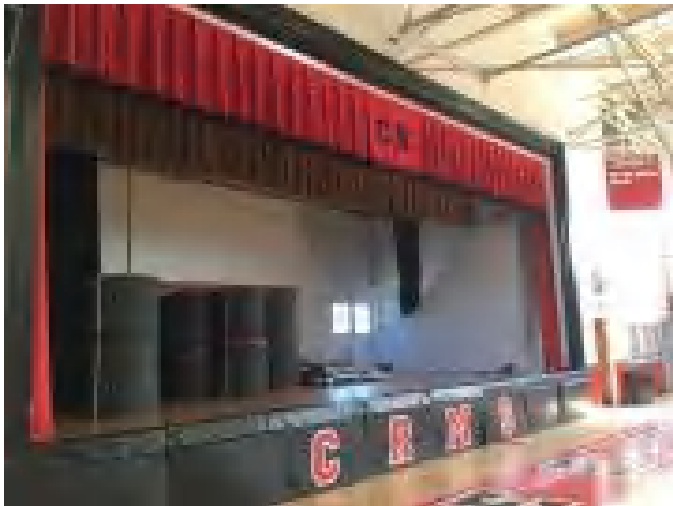
**System: E1020 - Institutional Equipment**

**Location:** Stage  
**Distress:** Beyond Service Life  
**Category:** Deferred Maintenance / Appearance  
**Priority:** 4 - Recommended (Years 6-10)  
**Correction:** Renew System  
**Qty:** 44,433.00  
**Unit of Measure:** S.F.  
**Estimate:** \$137,342.00  
**Assessor Name:** Terence Davis  
**Date Created:** 02/01/2017

**Notes:** Theater and stage equipment is aged and should be replaced.

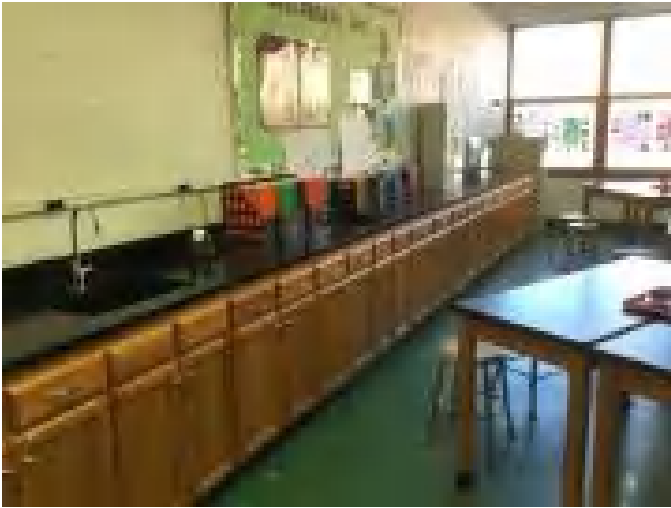
**System: E2010 - Fixed Furnishings**

**Location:** Throughout  
**Distress:** Beyond Service Life  
**Category:** Deferred Maintenance / Appearance  
**Priority:** 4 - Recommended (Years 6-10)  
**Correction:** Renew System  
**Qty:** 44,433.00  
**Unit of Measure:** S.F.  
**Estimate:** \$274,196.00  
**Assessor Name:** Terence Davis  
**Date Created:** 02/01/2017

**Notes:** The fixed furnishings are aged, in marginal condition, and should be replaced.

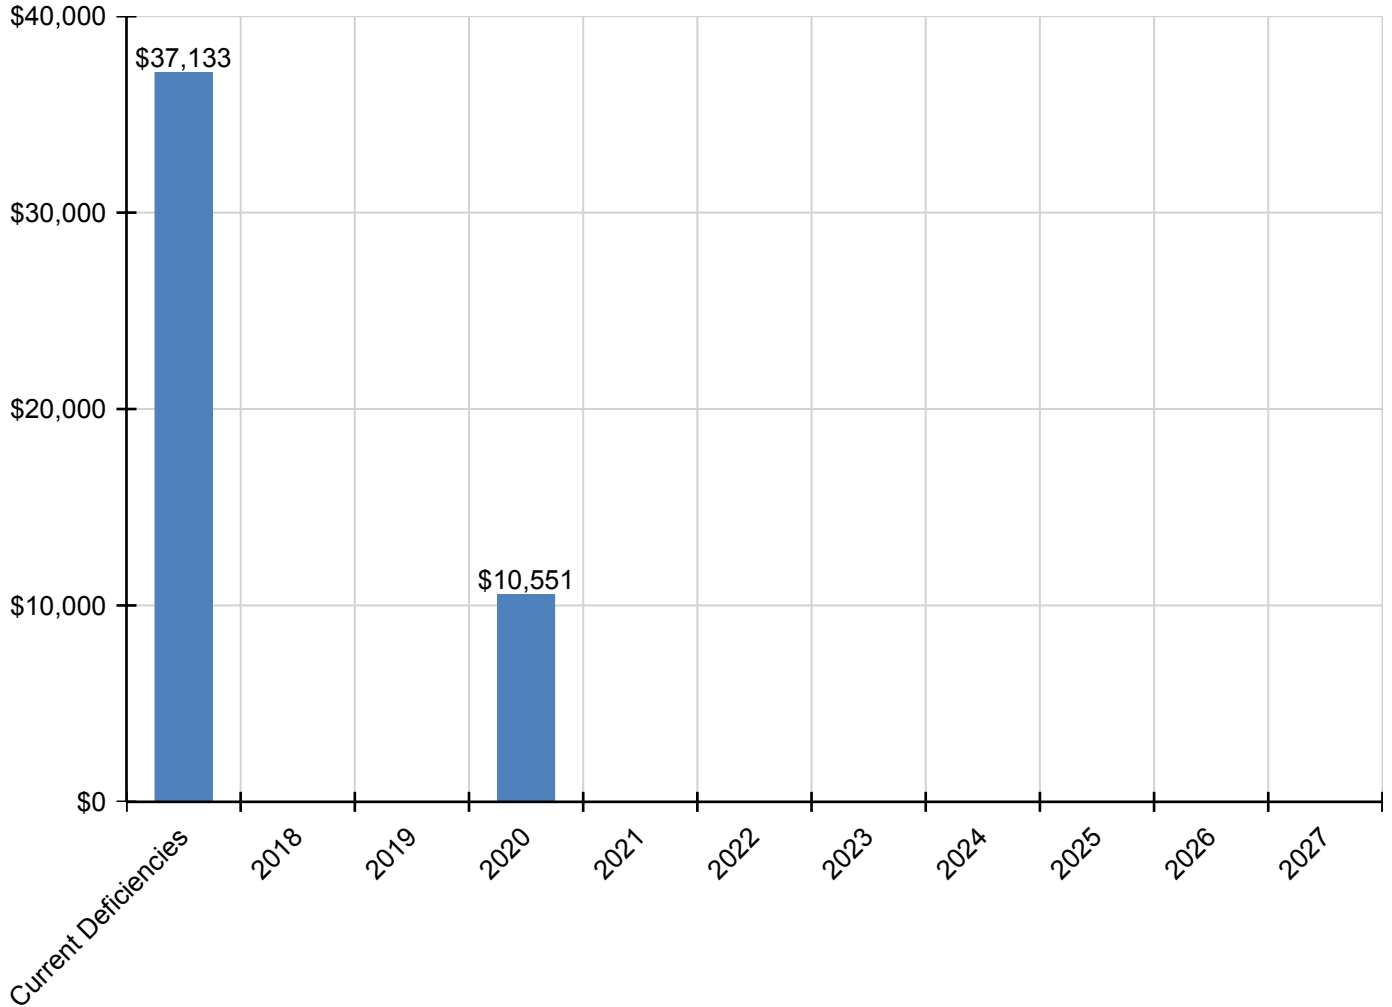
## Forecasted Capital Renewal Requirement

The following chart shows the current building deficiencies and forecasting capital renewal or sustainment requirements over the next ten years.

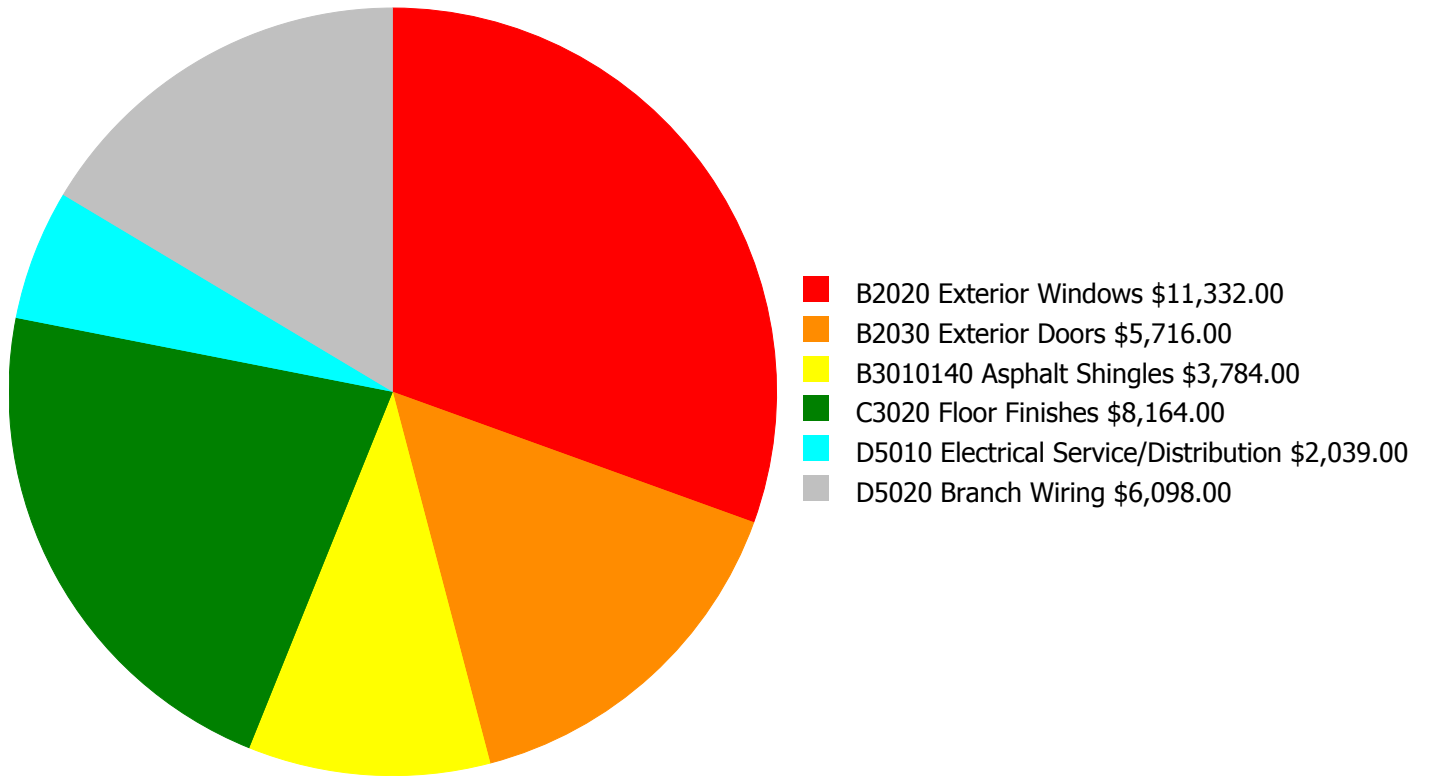
## Deficiency Summary by System

Current deficiencies included assemblies that have reached or exceeded their design life or components of the assemblies that are in need of repair. Assemblies that have reached their design life are identified as current deficiencies and assigned the distress 'Beyond Useful Life'. The following chart lists all current deficiencies associated with this facility.

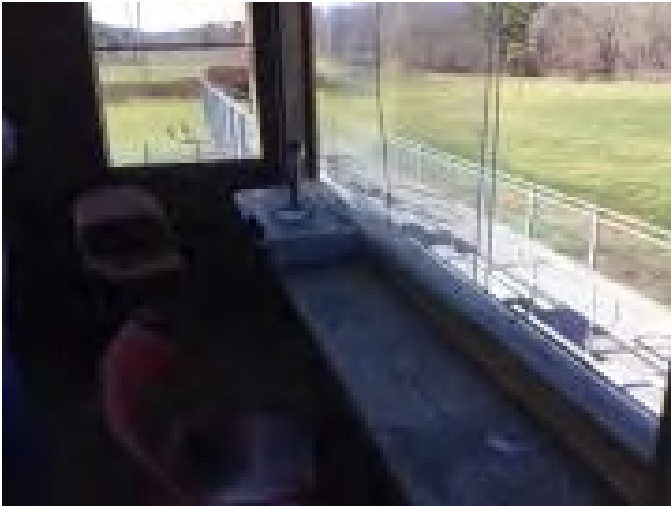
#### System: B2020 - Exterior Windows

**Location:** Throughout  
**Distress:** Failing  
**Category:** Deferred Maintenance / Appearance  
**Priority:** 3 - Necessary/Not Yet Critical (Years 2-5)  
**Correction:** Renew System  
**Qty:** 600.00  
**Unit of Measure:** S.F.  
**Estimate:** \$11,332.00  
**Assessor Name:** Eduardo Lopez  
**Date Created:** 02/01/2017

**Notes:** The plexi-glass, single pane windows are aged, warped, not energy efficient, and should be replaced.

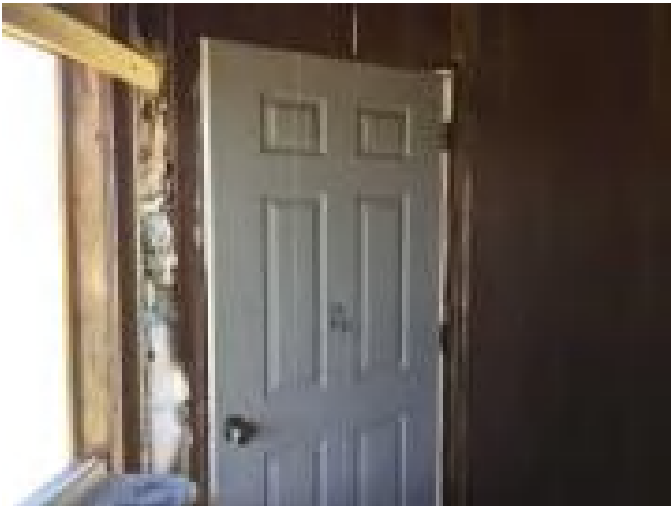
#### System: B2030 - Exterior Doors

**Location:** Entrance  
**Distress:** Damaged  
**Category:** Deferred Maintenance / Appearance  
**Priority:** 3 - Necessary/Not Yet Critical (Years 2-5)  
**Correction:** Renew System  
**Qty:** 600.00  
**Unit of Measure:** S.F.  
**Estimate:** \$5,716.00  
**Assessor Name:** Eduardo Lopez  
**Date Created:** 02/01/2017

**Notes:** The original exterior doors are aged, damaged, and should be replaced.

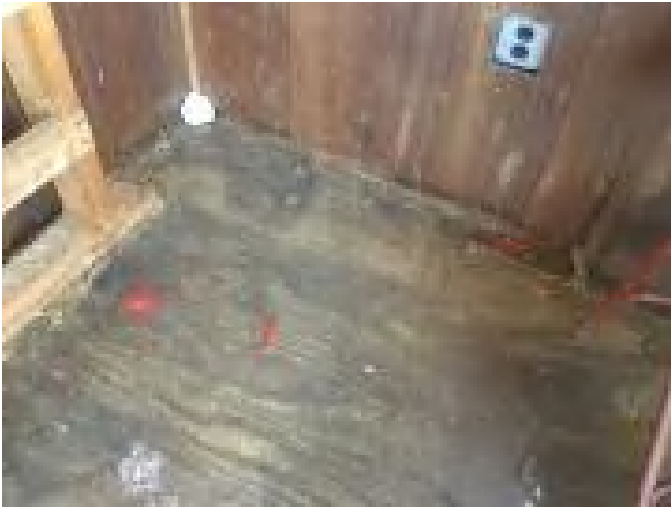
**System: C3020 - Floor Finishes**

**Location:** Throughout  
**Distress:** Beyond Service Life  
**Category:** Deferred Maintenance  
**Priority:** 3 - Necessary/Not Yet Critical (Years 2-5)  
**Correction:** Renew System  
**Qty:** 600.00  
**Unit of Measure:** S.F.  
**Estimate:** \$8,164.00  
**Assessor Name:** Eduardo Lopez  
**Date Created:** 02/01/2017

**Notes:** Flooring requires painting or sealing to protect building material.

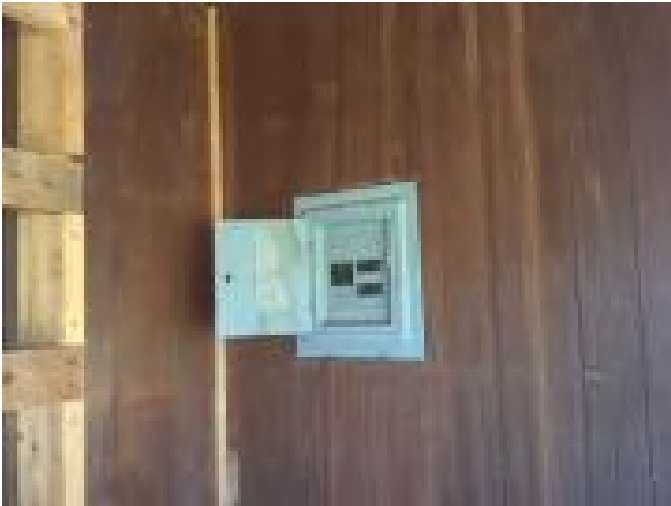
**System: D5010 - Electrical Service/Distribution**

**Location:** Throughout  
**Distress:** Beyond Service Life  
**Category:** Deferred Maintenance  
**Priority:** 3 - Necessary/Not Yet Critical (Years 2-5)  
**Correction:** Renew System  
**Qty:** 600.00  
**Unit of Measure:** S.F.  
**Estimate:** \$2,039.00  
**Assessor Name:** Eduardo Lopez  
**Date Created:** 02/01/2017

**Notes:** The original electrical service is operating but is in poor condition and should be replaced.

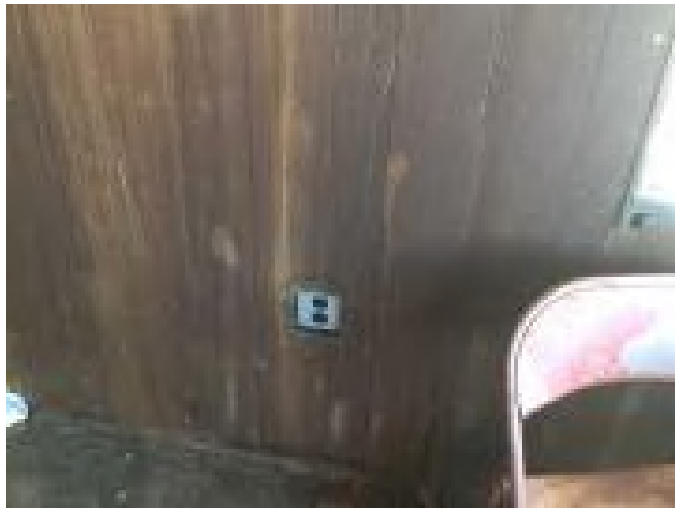
**System: D5020 - Branch Wiring**

**Location:** Throughout  
**Distress:** Beyond Service Life  
**Category:** Deferred Maintenance  
**Priority:** 3 - Necessary/Not Yet Critical (Years 2-5)  
**Correction:** Renew System  
**Qty:** 600.00  
**Unit of Measure:** S.F.  
**Estimate:** \$6,098.00  
**Assessor Name:** Eduardo Lopez  
**Date Created:** 02/01/2017

**Notes:** The original branch wiring system is operating, but is aged, in poor condition, and should be replaced.

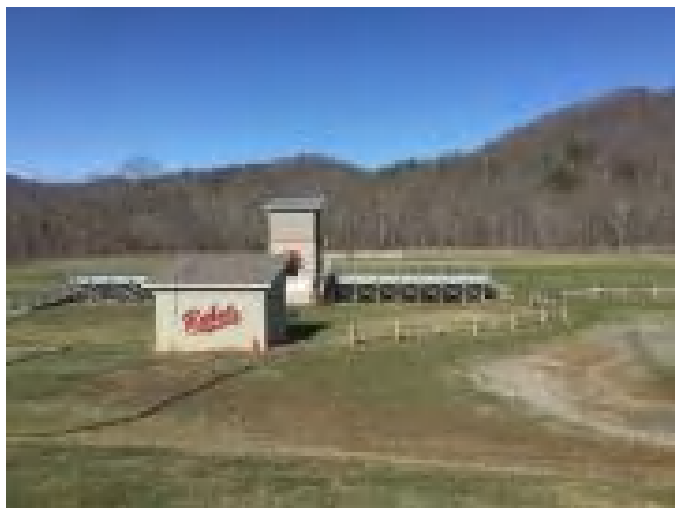
**System: B3010140 - Asphalt Shingles**

**Location:** Roof  
**Distress:** Beyond Service Life  
**Category:** Deferred Maintenance / Appearance  
**Priority:** 4 - Recommended (Years 6-10)  
**Correction:** Renew System  
**Qty:** 600.00  
**Unit of Measure:** S.F.  
**Estimate:** \$3,784.00  
**Assessor Name:** Eduardo Lopez  
**Date Created:** 02/01/2017

**Notes:** The asphalt shingle roofing is aged, damaged and should be replaced.

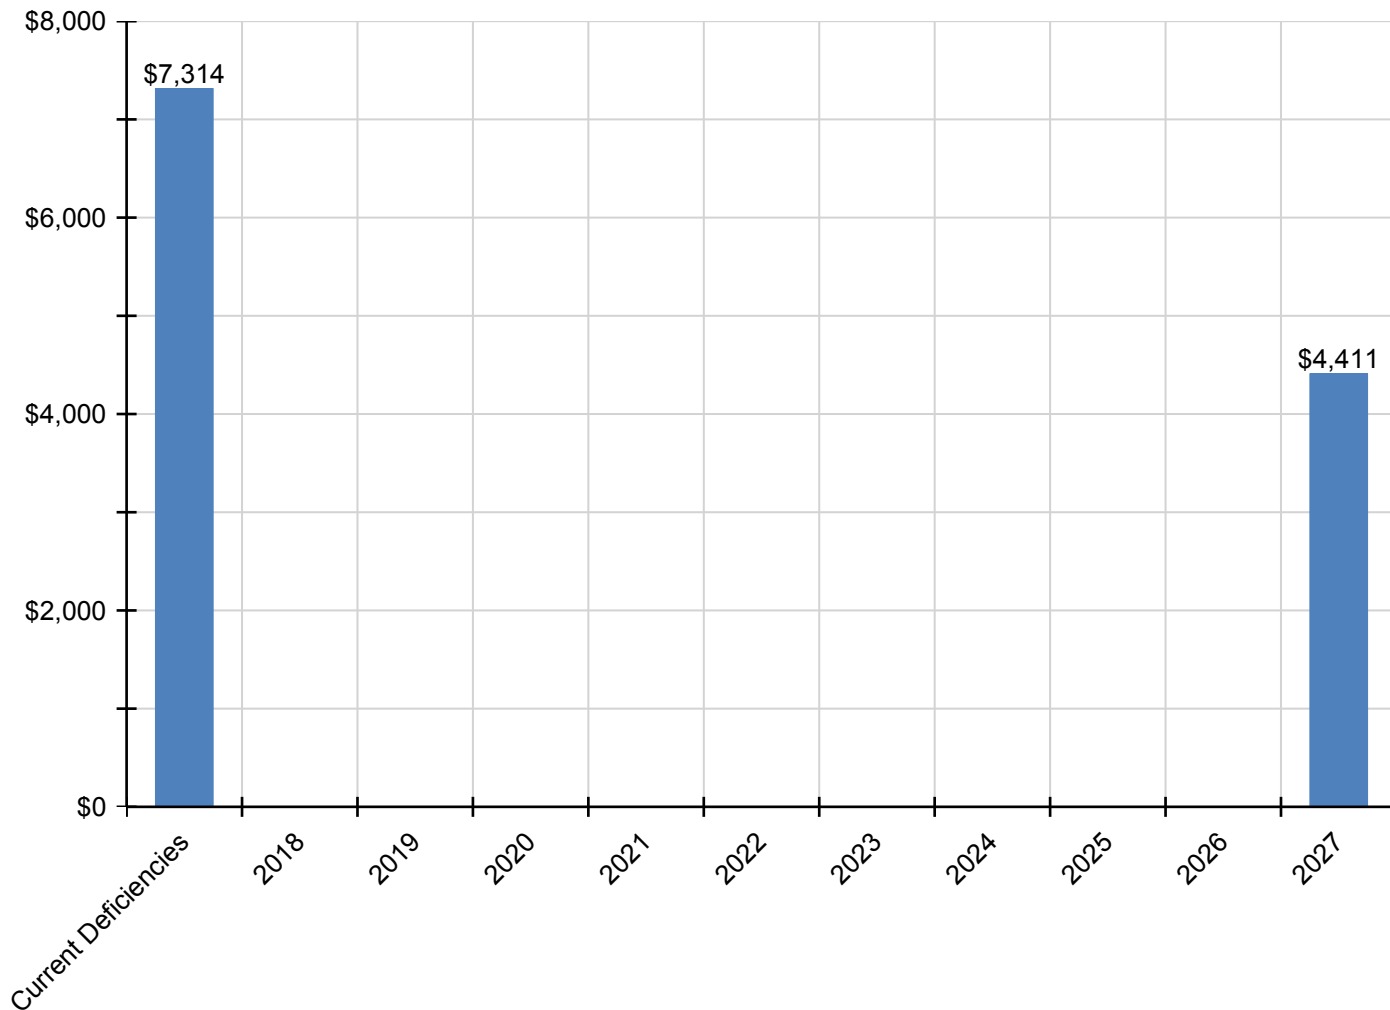
### Forecasted Capital Renewal Requirement

The following chart shows the current building deficiencies and forecasting capital renewal or sustainment requirements over the next ten years.

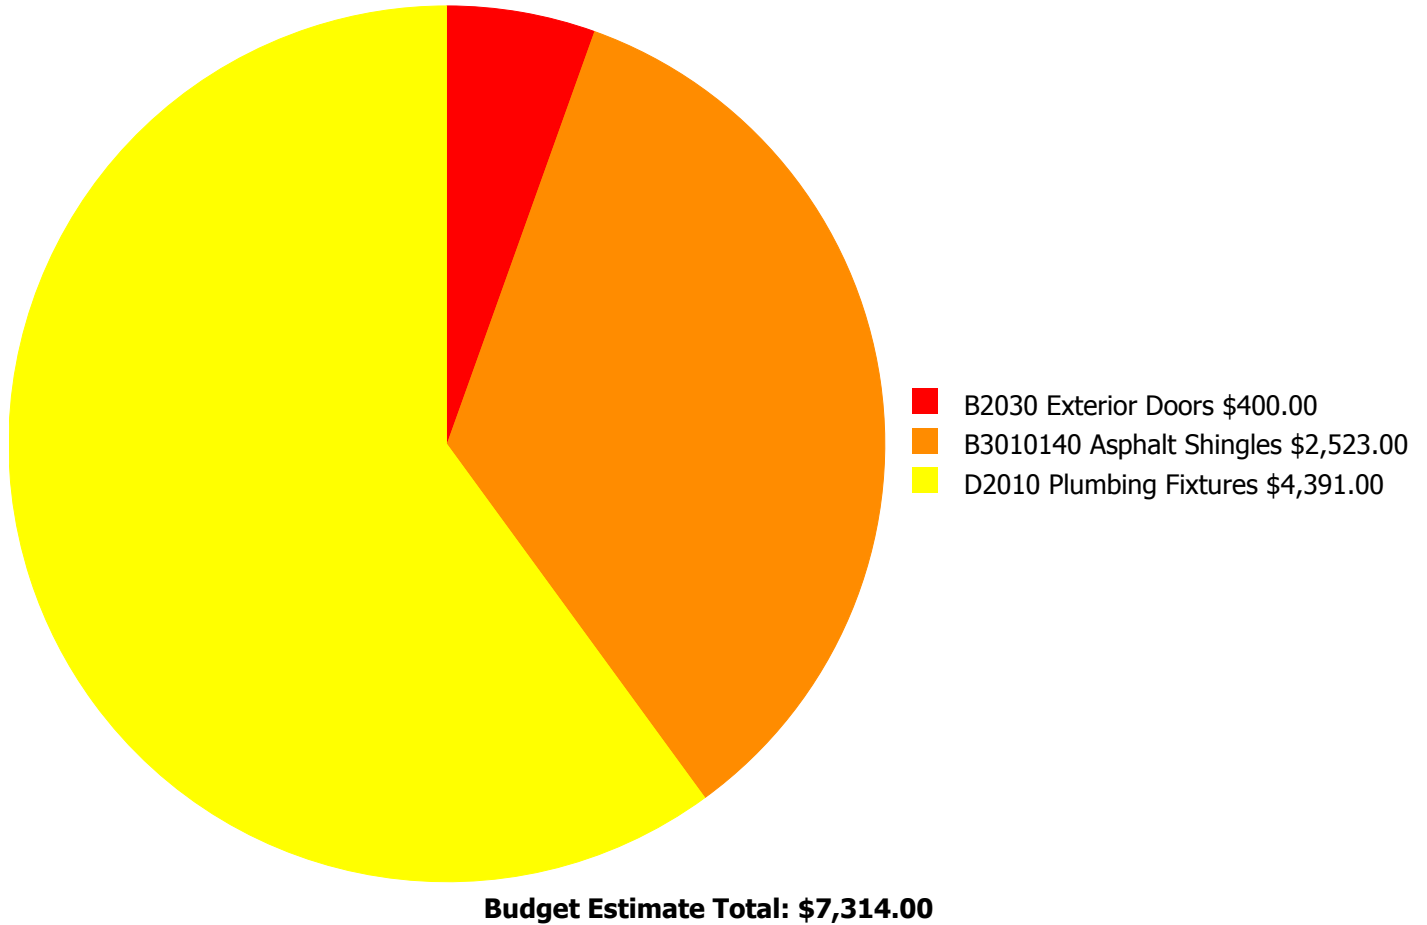
## Deficiency Summary by System

Current deficiencies included assemblies that have reached or exceeded their design life or components of the assemblies that are in need of repair. Assemblies that have reached their design life are identified as current deficiencies and assigned the distress 'Beyond Useful Life'. The following chart lists all current deficiencies associated with this facility.

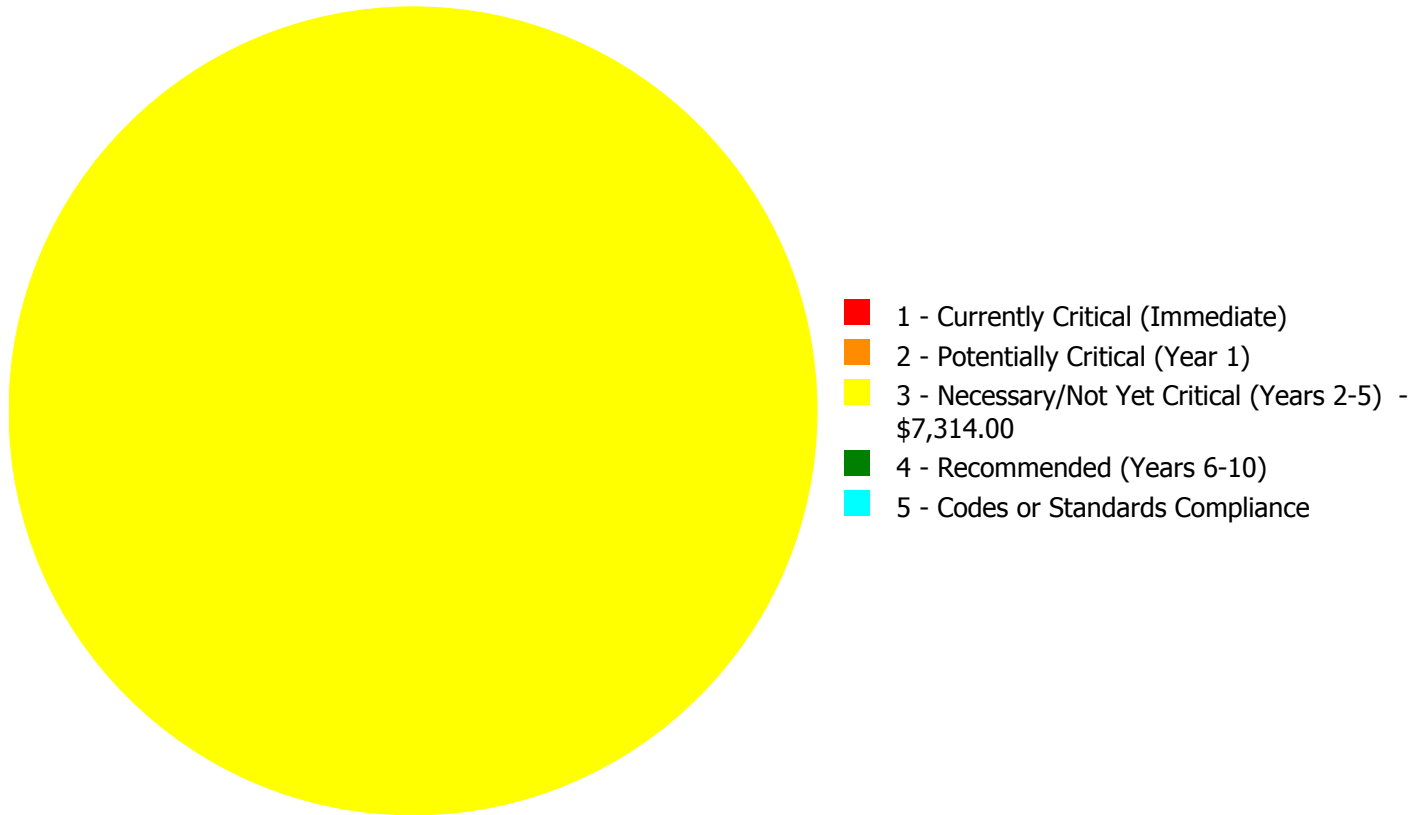
## Deficiency Summary by Priority

The following chart shows the total repair costs broken down by priority. Assessors assigned deficiencies within eCOMET to one of the following priority categories:

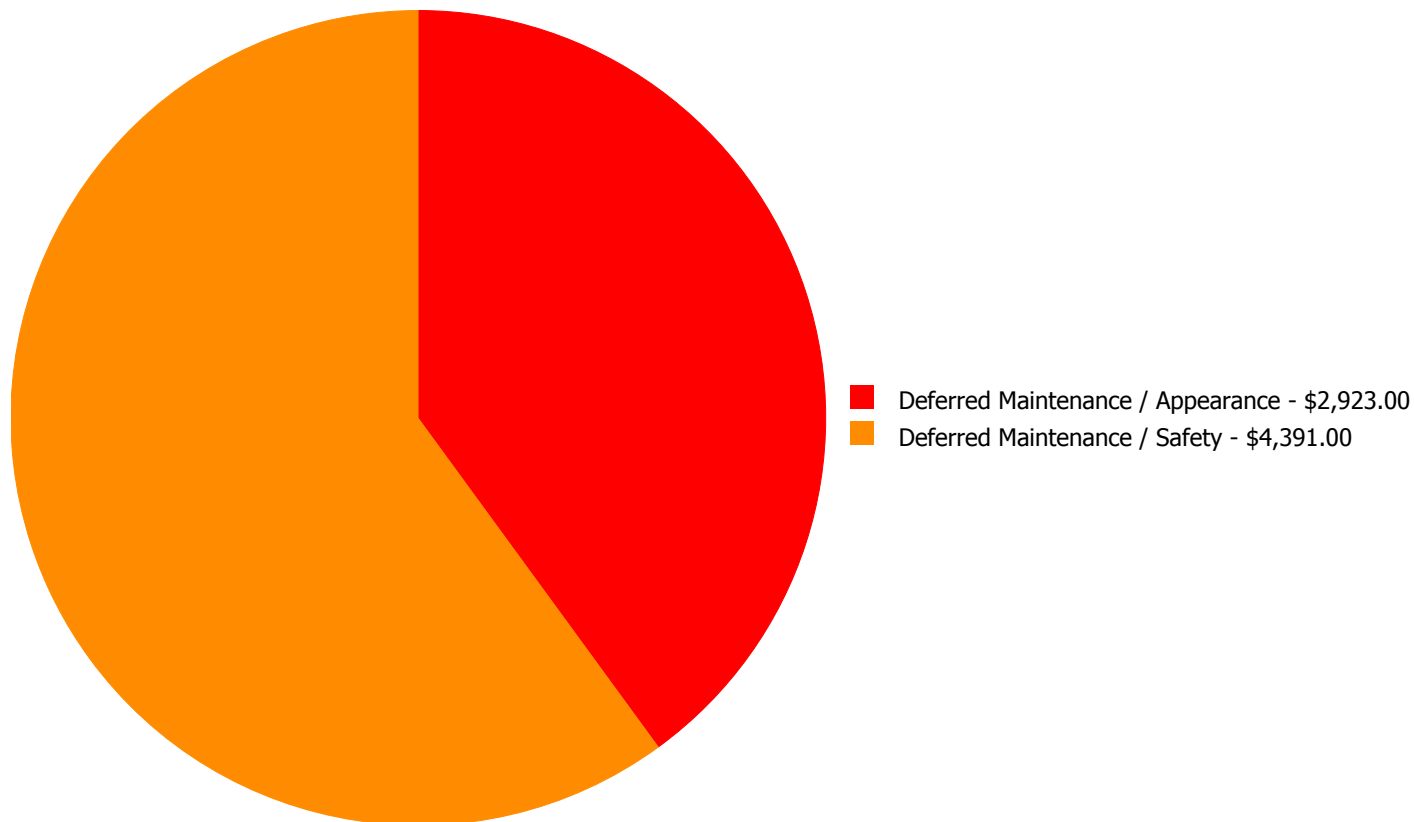
### Deficiency Summary by Category

The following chart shows the total repair costs broken down by deficiency categories. Assessors assigned deficiencies to one of the following categories:

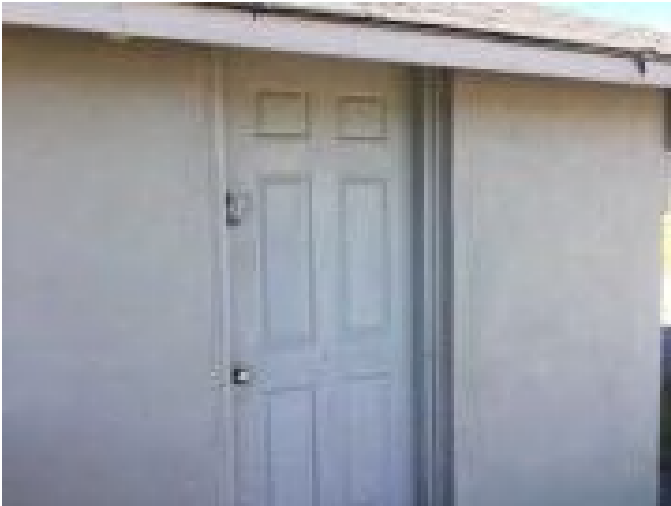
#### **System: B2030 - Exterior Doors**

**Location:** Throughout  
**Distress:** Damaged  
**Category:** Deferred Maintenance / Appearance  
**Priority:** 3 - Necessary/Not Yet Critical (Years 2-5)  
**Correction:** Renew System  
**Qty:** 400.00  
**Unit of Measure:** S.F.  
**Estimate:** \$400.00  
**Assessor Name:** Eduardo Lopez  
**Date Created:** 02/01/2017

**Notes:** The original exterior doors are aged, damaged, and should be replaced.

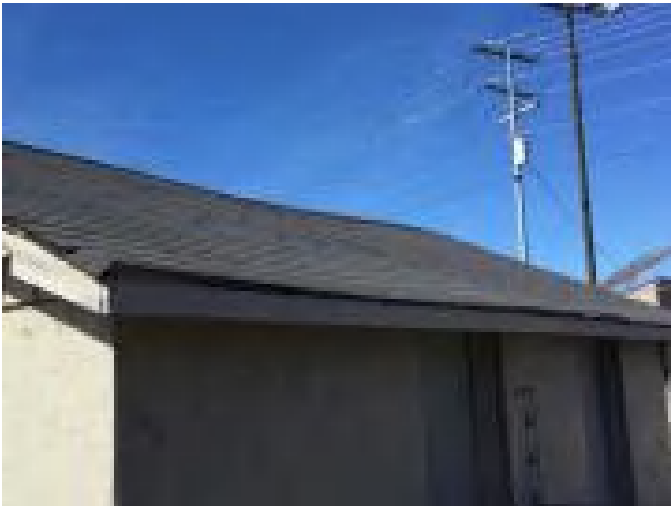
#### **System: B3010140 - Asphalt Shingles**

**Location:** Roof  
**Distress:** Failing  
**Category:** Deferred Maintenance / Appearance  
**Priority:** 3 - Necessary/Not Yet Critical (Years 2-5)  
**Correction:** Renew System  
**Qty:** 400.00  
**Unit of Measure:** S.F.  
**Estimate:** \$2,523.00  
**Assessor Name:** Eduardo Lopez  
**Date Created:** 02/01/2017

**Notes:** The asphalt shingle roofing is aged, damaged and should be replaced.

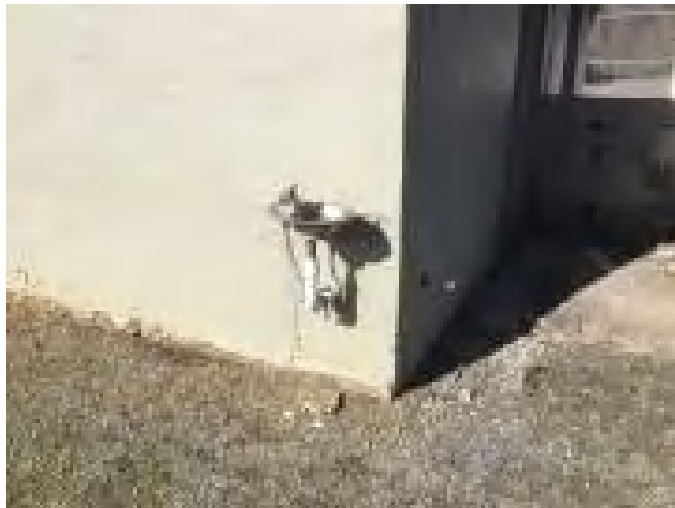
**System: D2010 - Plumbing Fixtures**

**Location:** Exterior  
**Distress:** Beyond Service Life  
**Category:** Deferred Maintenance / Safety  
**Priority:** 3 - Necessary/Not Yet Critical (Years 2-5)  
**Correction:** Renew System  
**Qty:** 400.00  
**Unit of Measure:** S.F.  
**Estimate:** \$4,391.00  
**Assessor Name:** Eduardo Lopez  
**Date Created:** 02/01/2017

**Notes:** Plumbing fixtures are in operational conditions. However, they are aged, not ADA compliant and should be replaced with a low-flow water fixtures.

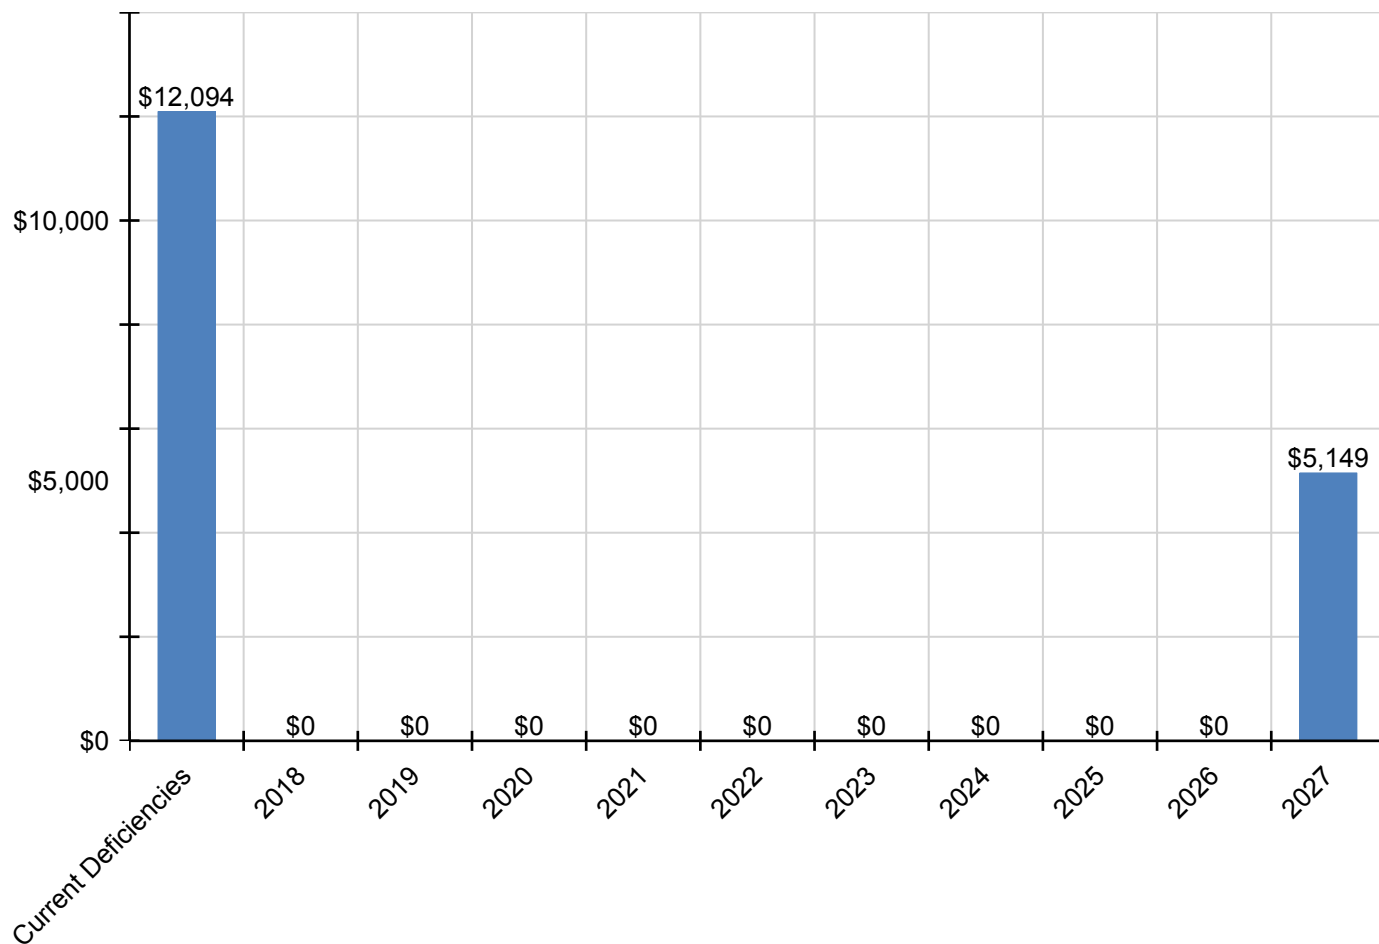
### Forecasted Capital Renewal Requirement

The following chart shows the current building deficiencies and forecasting capital renewal or sustainment requirements over the next ten years.
