NC School District/995 Yancey County/High School

# Mountain Heritage High

## Campus Assessment Report

March 7, 2017

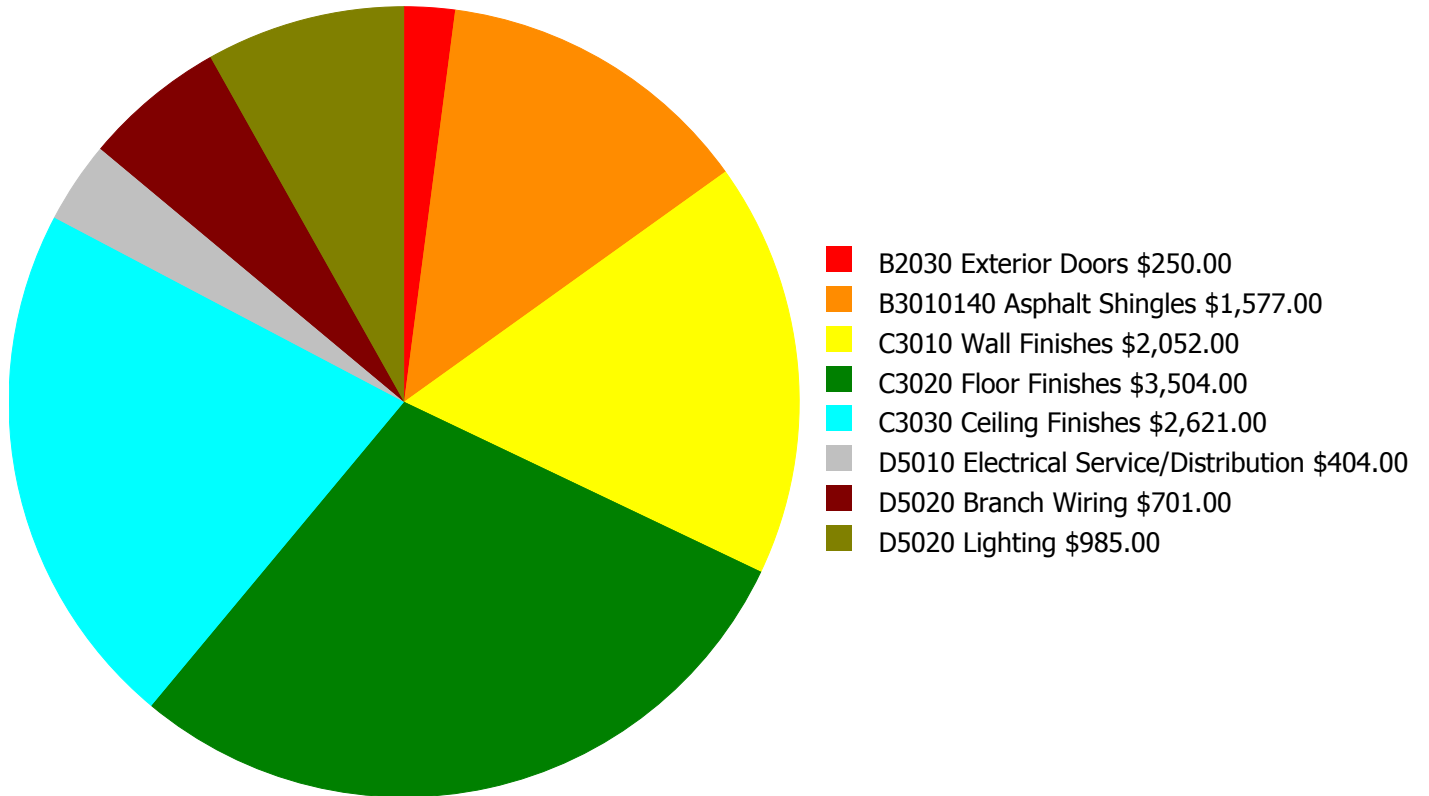
## Deficiency Summary by System

Current deficiencies included assemblies that have reached or exceeded their design life or components of the assemblies that are in need of repair. Assemblies that have reached their design life are identified as current deficiencies and assigned the distress 'Beyond Useful Life'. The following chart lists all current deficiencies associated with this facility.

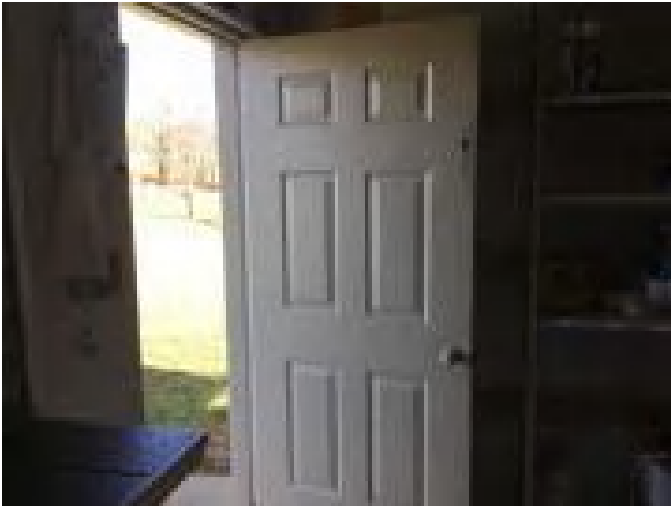
#### System: B2030 - Exterior Doors

**Location:** Entrances  
**Distress:** Beyond Service Life  
**Category:** Deferred Maintenance / Appearance  
**Priority:** 3 - Necessary/Not Yet Critical (Years 2-5)  
**Correction:** Renew System  
**Qty:** 250.00  
**Unit of Measure:** S.F.  
**Estimate:** \$250.00  
**Assessor Name:** Eduardo Lopez  
**Date Created:** 02/01/2017

**Notes:** The original exterior doors are aged, damaged, and should be replaced.

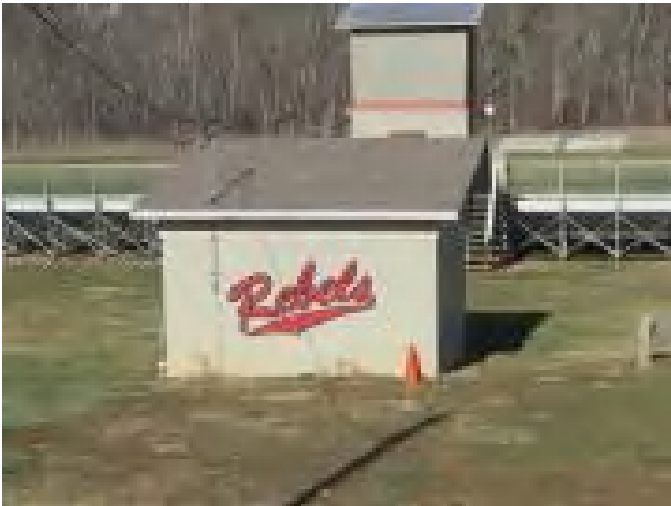
#### System: B3010140 - Asphalt Shingles

**Location:** Roof  
**Distress:** Beyond Service Life  
**Category:** Deferred Maintenance / Appearance  
**Priority:** 3 - Necessary/Not Yet Critical (Years 2-5)  
**Correction:** Renew System  
**Qty:** 250.00  
**Unit of Measure:** S.F.  
**Estimate:** \$1,577.00  
**Assessor Name:** Eduardo Lopez  
**Date Created:** 02/01/2017

**Notes:** The asphalt shingle roofing is aged, damaged and should be replaced.

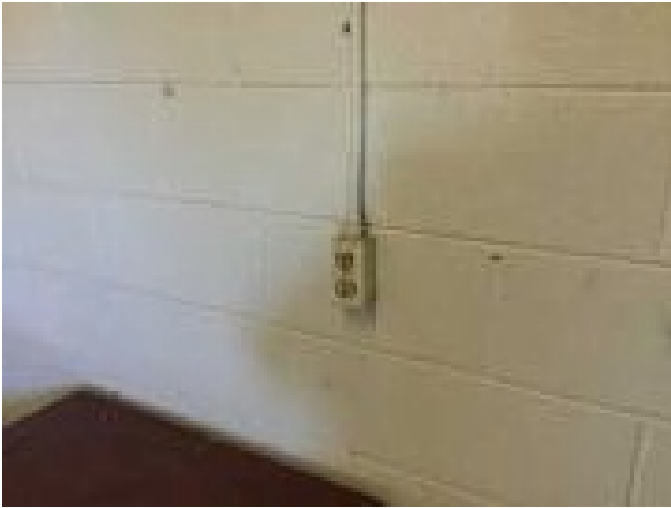
**System: C3010 - Wall Finishes**

**Location:** Throughout  
**Distress:** Beyond Service Life  
**Category:** Deferred Maintenance / Appearance  
**Priority:** 3 - Necessary/Not Yet Critical (Years 2-5)  
**Correction:** Renew System  
**Qty:** 250.00  
**Unit of Measure:** S.F.  
**Estimate:** \$2,052.00  
**Assessor Name:** Eduardo Lopez  
**Date Created:** 02/01/2017

**Notes:** The wall paint is damaged, fading, stained, and should be re-painted.

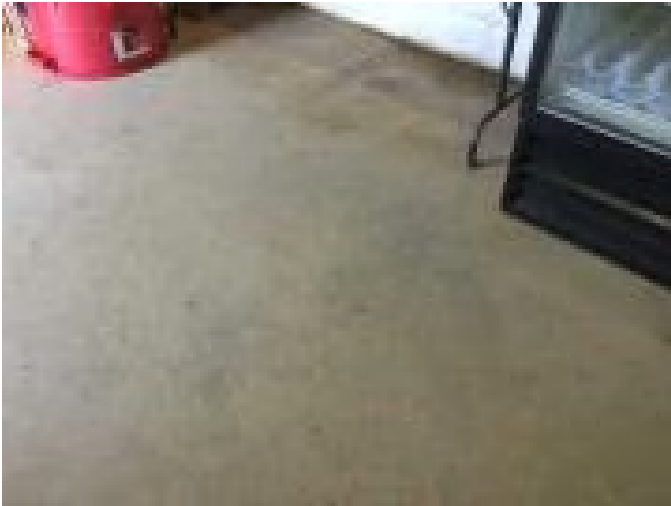
**System: C3020 - Floor Finishes**

**Location:** Throughout  
**Distress:** Failing  
**Category:** Deferred Maintenance / Appearance  
**Priority:** 3 - Necessary/Not Yet Critical (Years 2-5)  
**Correction:** Renew System  
**Qty:** 250.00  
**Unit of Measure:** S.F.  
**Estimate:** \$3,504.00  
**Assessor Name:** Eduardo Lopez  
**Date Created:** 02/01/2017

**Notes:** The original floor finish is worn and no longer effective for protection and should be replaced.

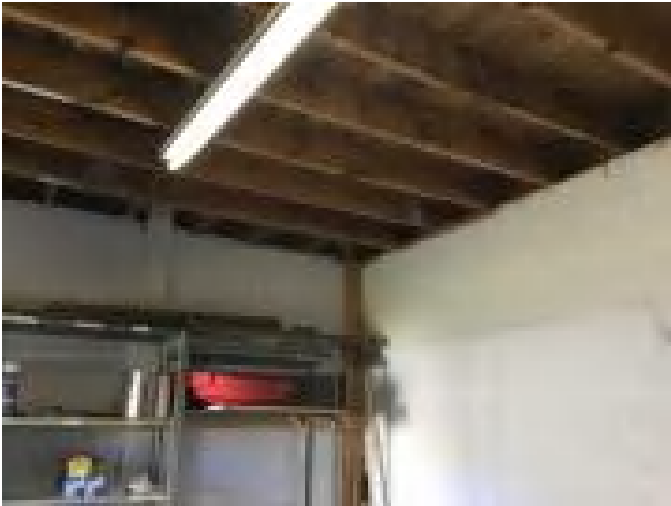
**System: C3030 - Ceiling Finishes**

**Location:** Throughout  
**Distress:** Missing  
**Category:** Deferred Maintenance / Energy  
**Priority:** 3 - Necessary/Not Yet Critical (Years 2-5)  
**Correction:** Renew System  
**Qty:** 250.00  
**Unit of Measure:** S.F.  
**Estimate:** \$2,621.00  
**Assessor Name:** Eduardo Lopez  
**Date Created:** 02/01/2017

**Notes:** Ceiling cavities should be insulated for thermal protection and covering installed.

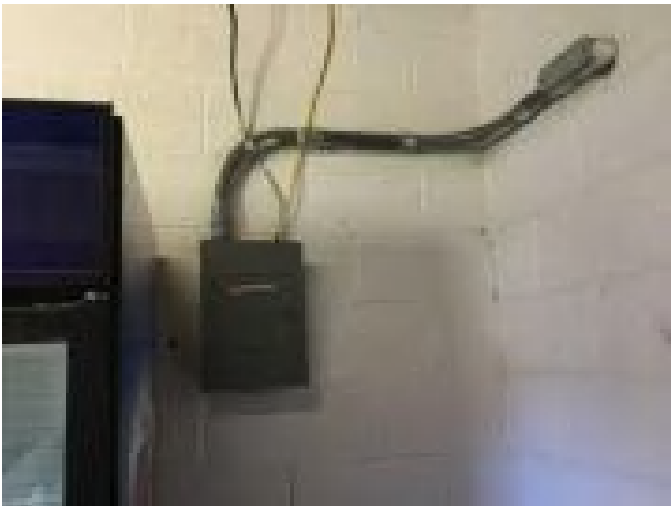
**System: D5010 - Electrical Service/Distribution**

**Location:** Throughout  
**Distress:** Beyond Service Life  
**Category:** Deferred Maintenance  
**Priority:** 3 - Necessary/Not Yet Critical (Years 2-5)  
**Correction:** Renew System  
**Qty:** 250.00  
**Unit of Measure:** S.F.  
**Estimate:** \$404.00  
**Assessor Name:** Eduardo Lopez  
**Date Created:** 02/01/2017

**Notes:** The original electrical service is operating but is in poor condition and should be replaced.

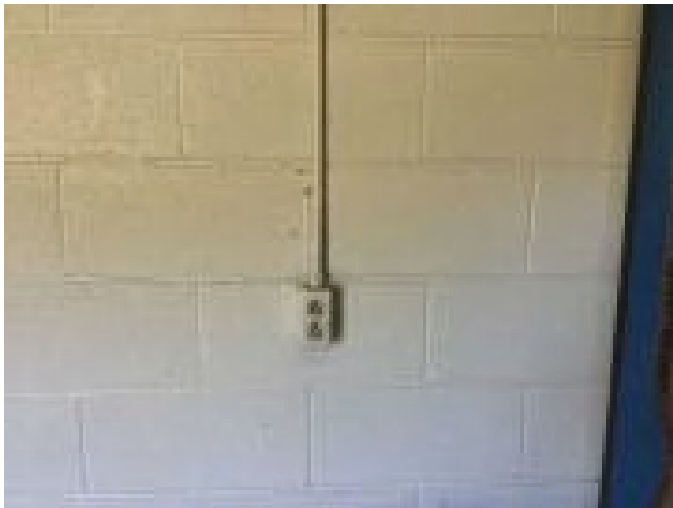
**System: D5020 - Branch Wiring**

**Location:** Throughout  
**Distress:** Beyond Service Life  
**Category:** Deferred Maintenance  
**Priority:** 3 - Necessary/Not Yet Critical (Years 2-5)  
**Correction:** Renew System  
**Qty:** 250.00  
**Unit of Measure:** S.F.  
**Estimate:** \$701.00  
**Assessor Name:** Eduardo Lopez  
**Date Created:** 02/01/2017

**Notes:** The original branch wiring system is operating, but is aged, in poor condition, and should be replaced.

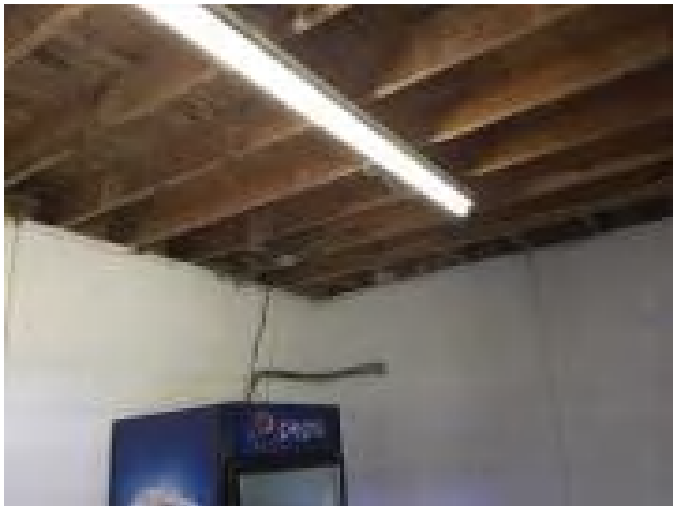
**System: D5020 - Lighting**

**Location:** Throughout  
**Distress:** Beyond Service Life  
**Category:** Deferred Maintenance  
**Priority:** 3 - Necessary/Not Yet Critical (Years 2-5)  
**Correction:** Renew System  
**Qty:** 250.00  
**Unit of Measure:** S.F.  
**Estimate:** \$985.00  
**Assessor Name:** Eduardo Lopez  
**Date Created:** 02/01/2017

**Notes:** The original lighting system is operating, but is aged, in poor condition, and should be replaced.

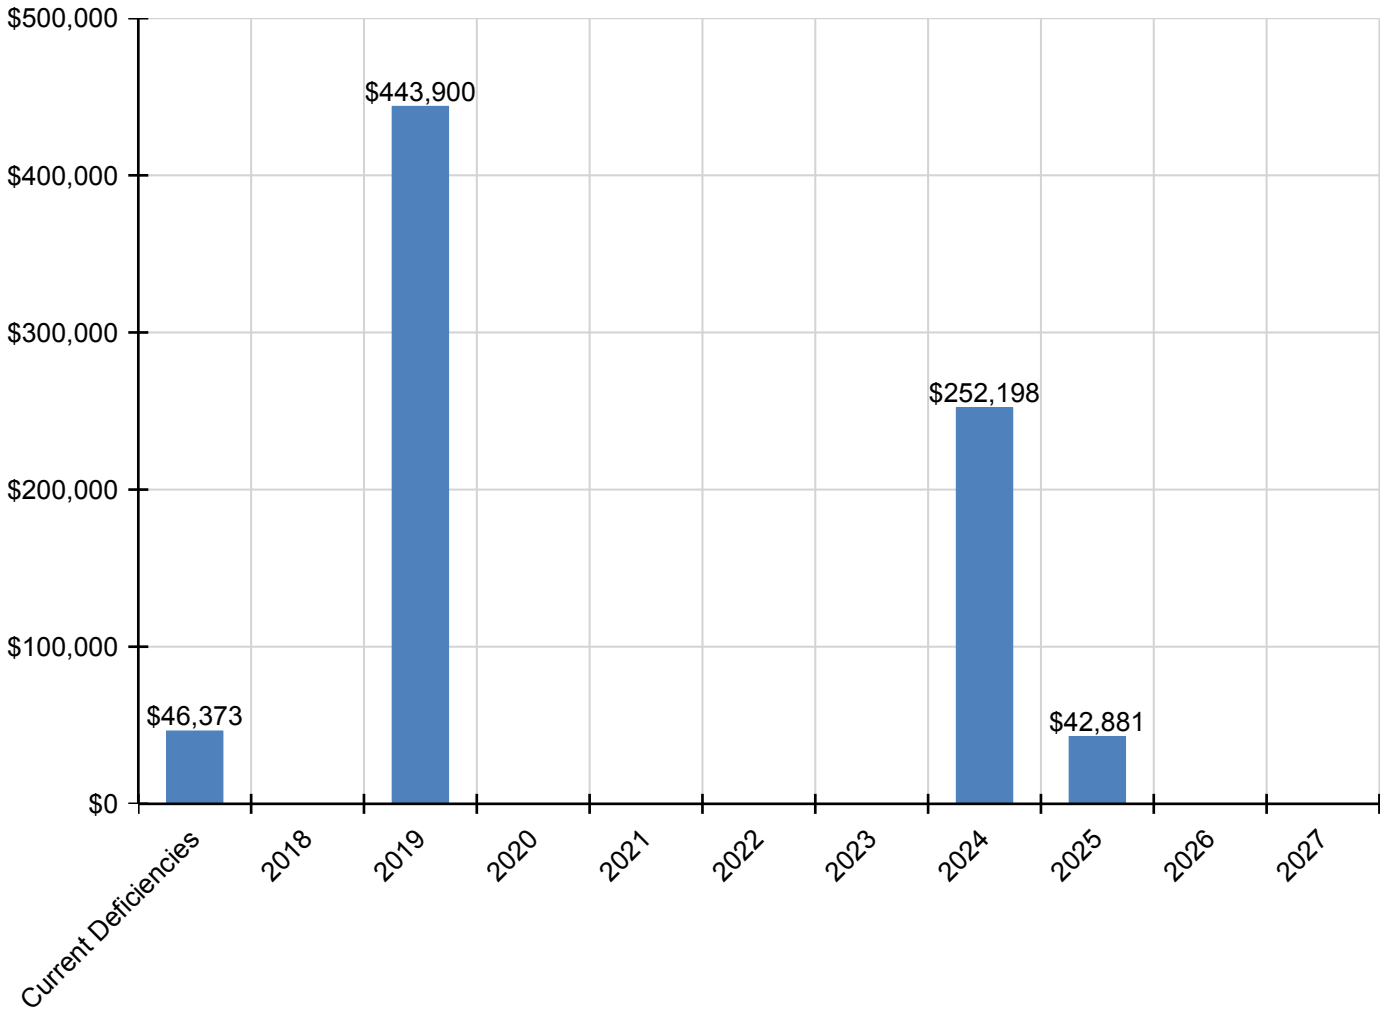
## Forecasted Capital Renewal Requirement

The following chart shows the current building deficiencies and forecasting capital renewal or sustainment requirements over the next ten years.

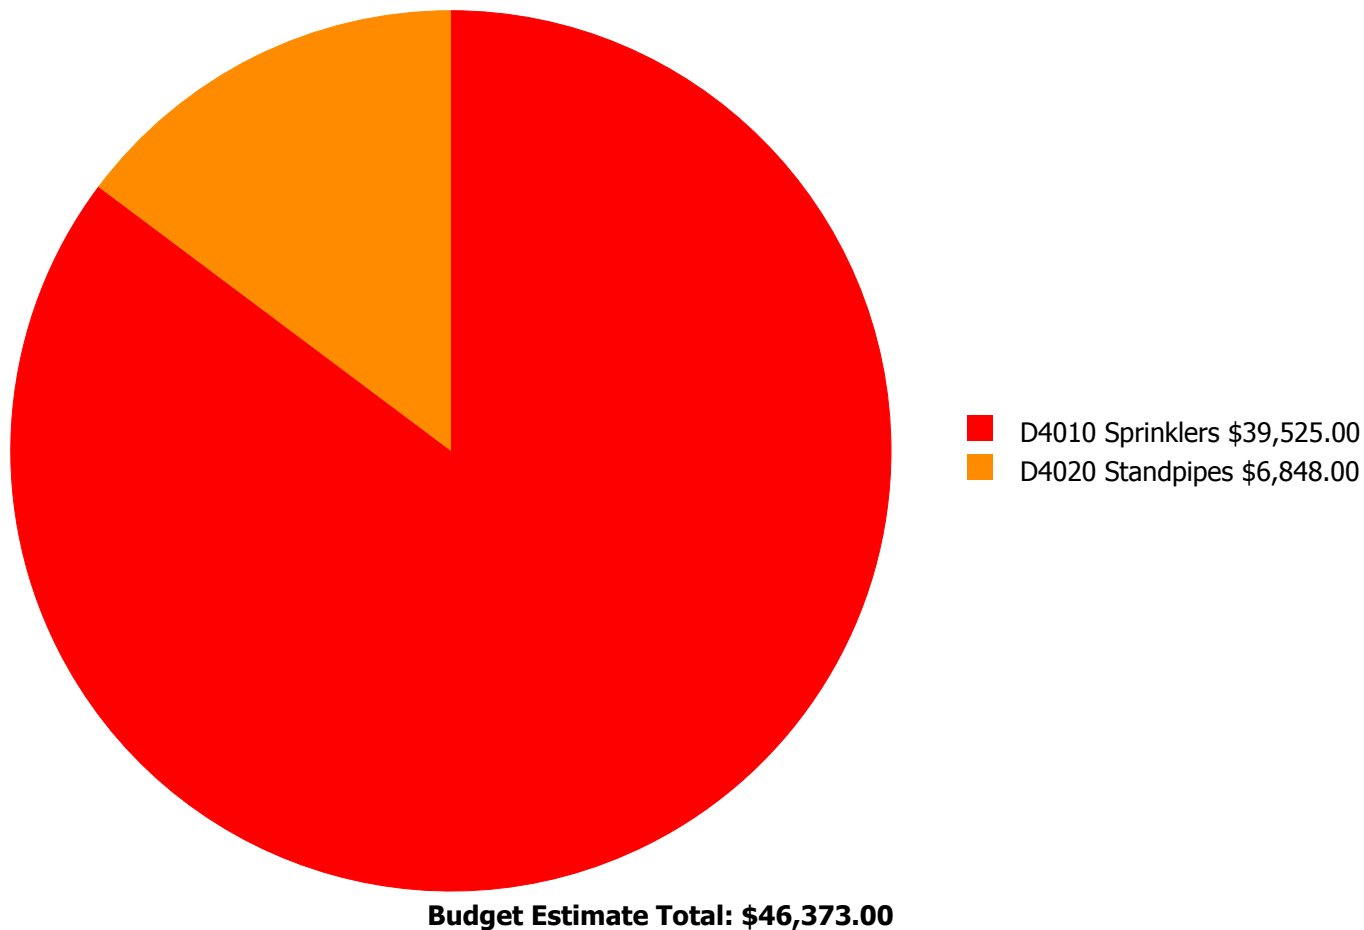
### Deficiency Summary by System

Current deficiencies included assemblies that have reached or exceeded their design life or components of the assemblies that are in need of repair. Assemblies that have reached their design life are identified as current deficiencies and assigned the distress 'Beyond Useful Life'. The following chart lists all current deficiencies associated with this facility.

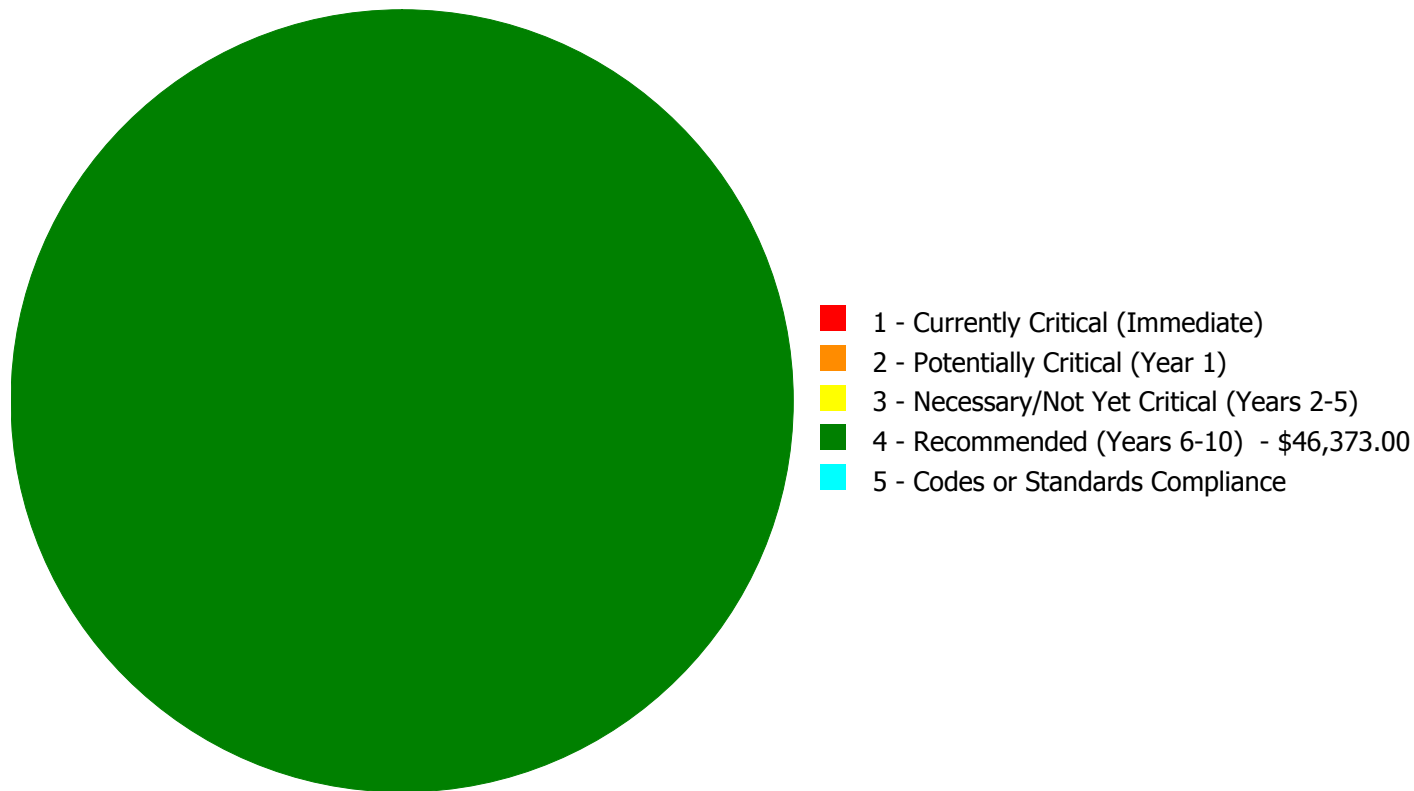
## Deficiency Summary by Priority

The following chart shows the total repair costs broken down by priority. Assessors assigned deficiencies within eCOMET to one of the following priority categories:

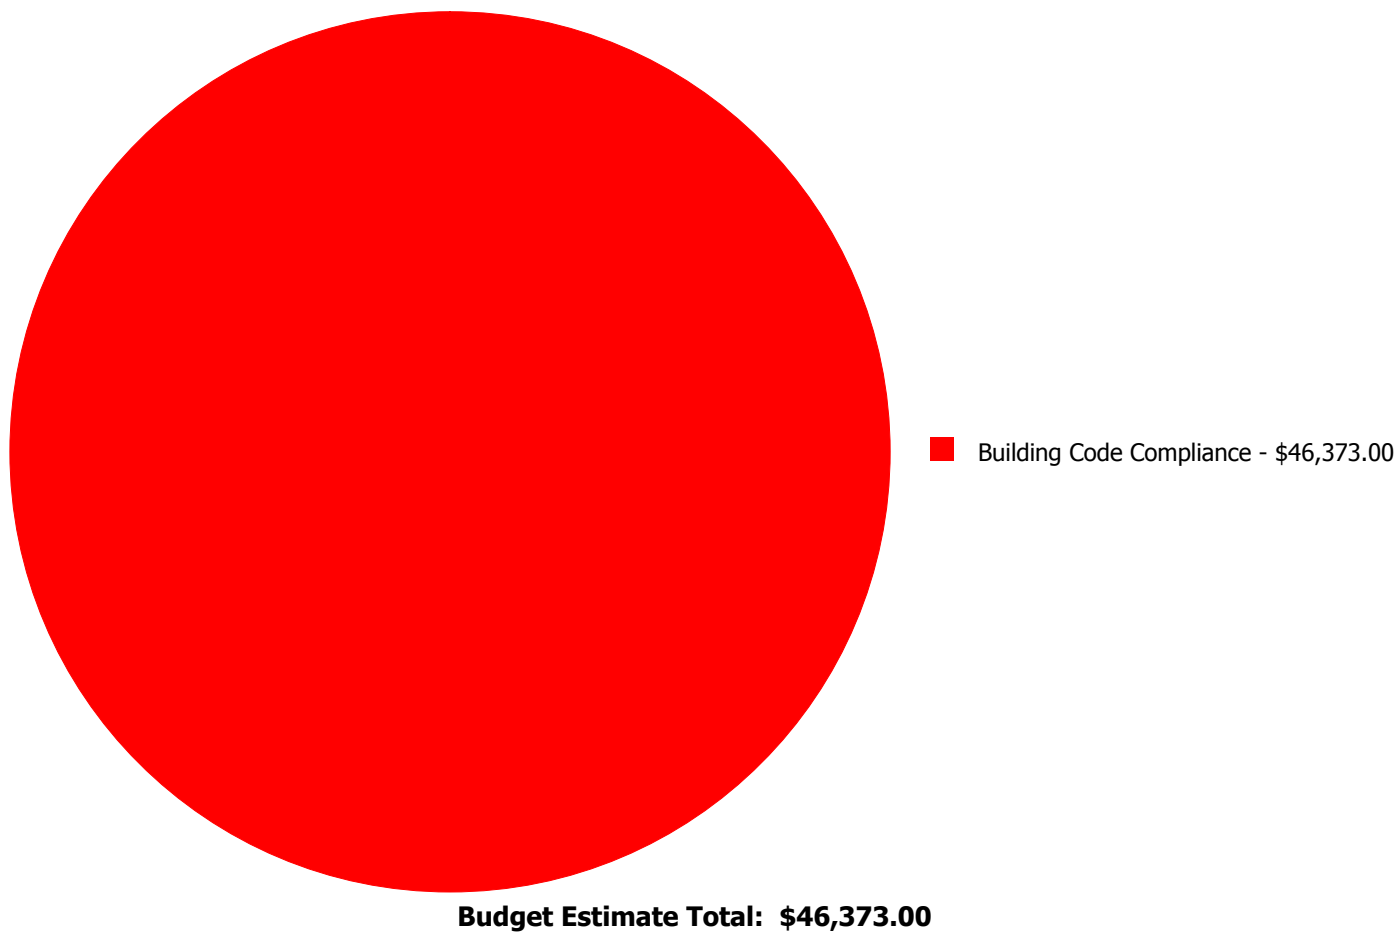
## Deficiency Summary by Category

The following chart shows the total repair costs broken down by deficiency categories. Assessors assigned deficiencies to one of the following categories:

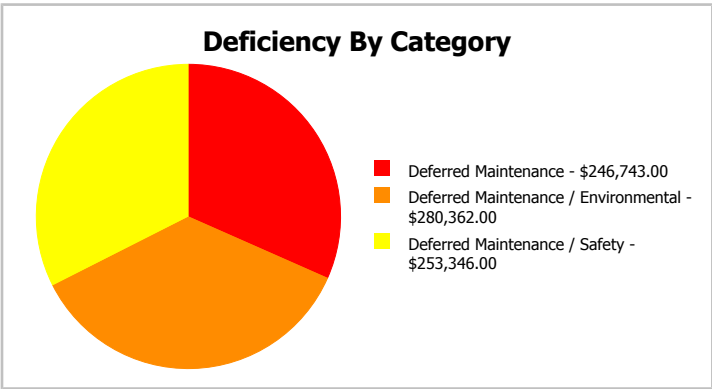
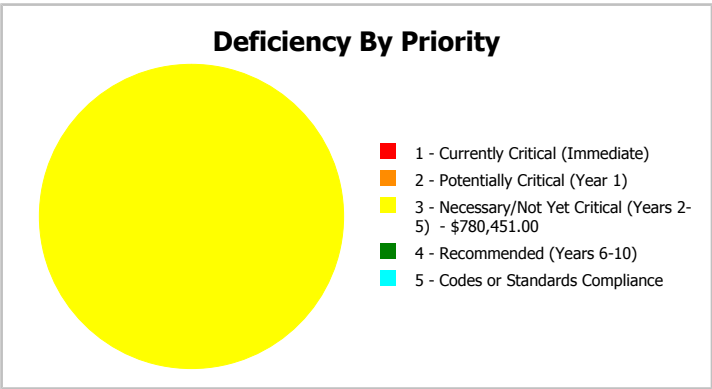
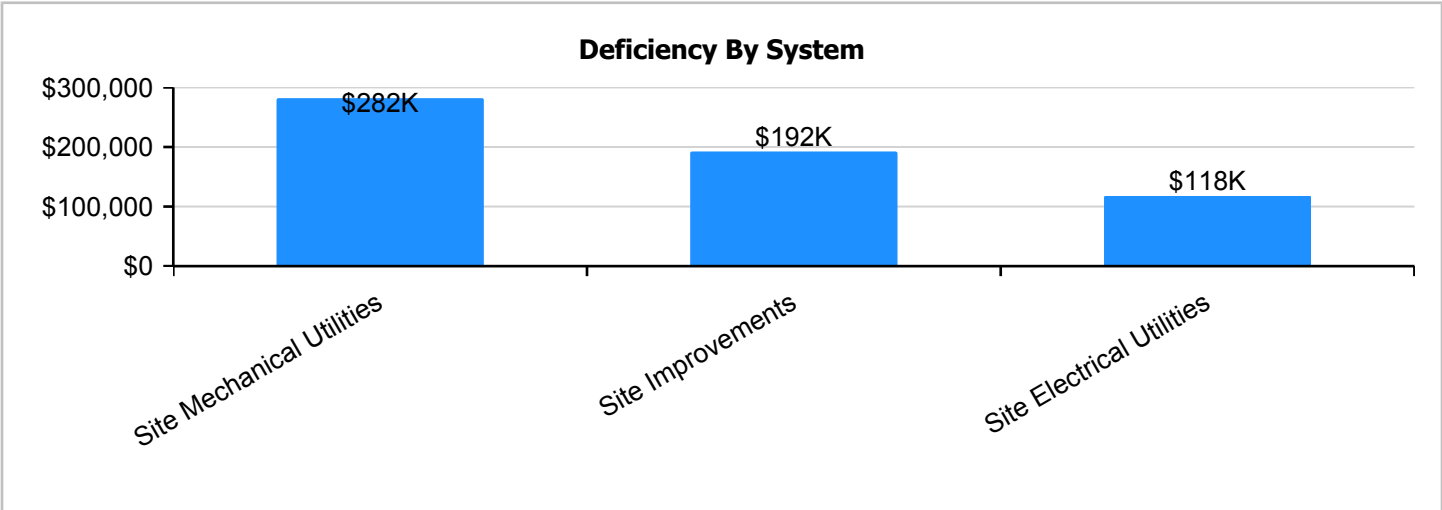
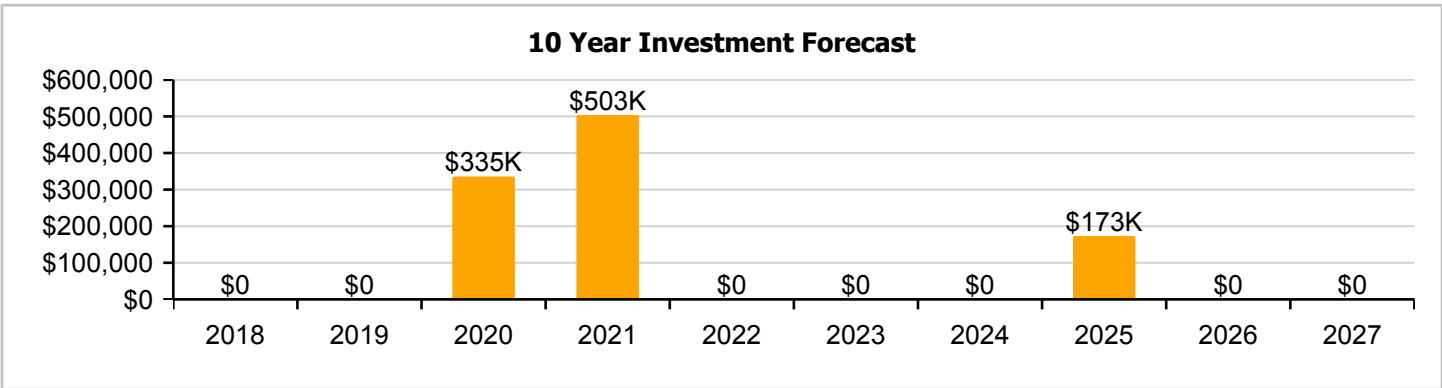
**Dashboard Summary**

Function:	MS -Middle School	Gross Area:	54,577
Year Built:	1958	Last Renovation:	
Repair Cost:	\$780,451	Replacement Value:	\$1,919,471
FCI:	40.66 %	RSLI%:	18.04 %

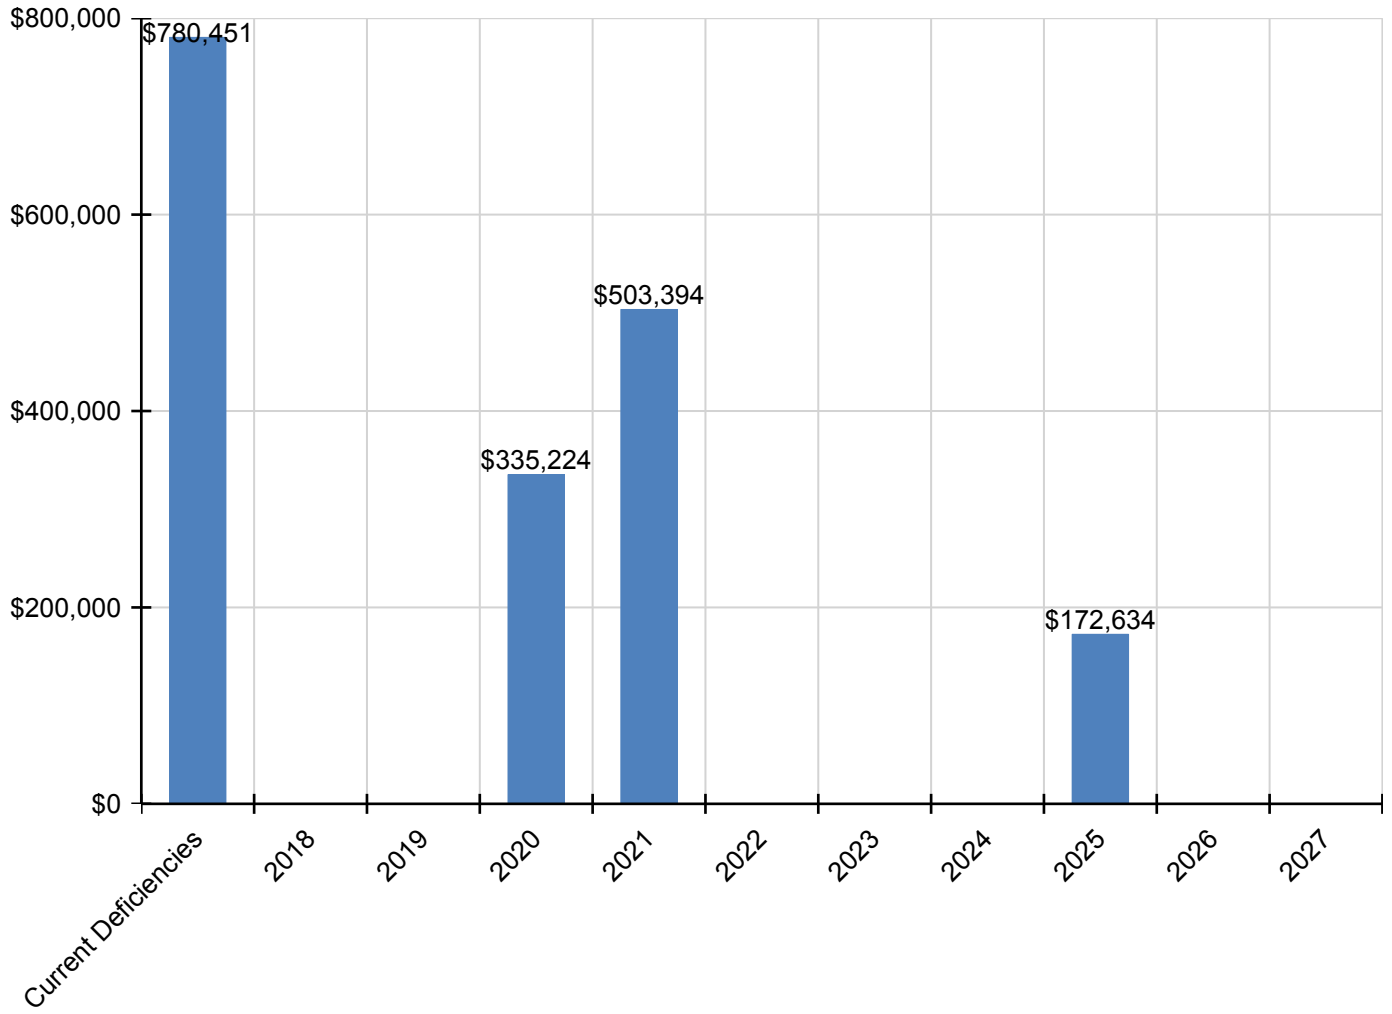
## Forecasted Capital Renewal Requirement

The following chart shows the current building deficiencies and forecasting capital renewal or sustainment requirements over the next ten years.

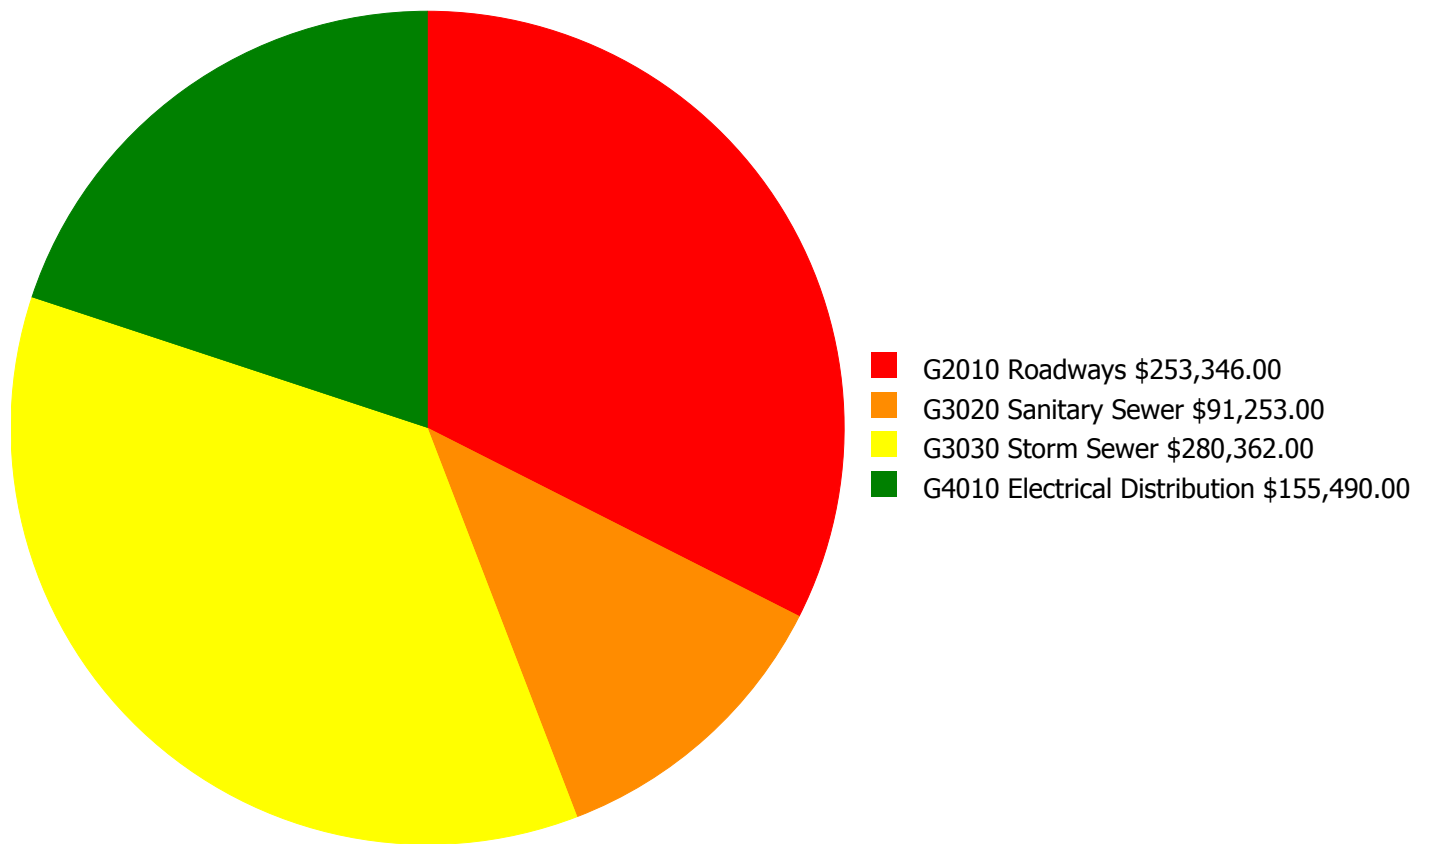
## Deficiency Summary by System

Current deficiencies included assemblies that have reached or exceeded their design life or components of the assemblies that are in need of repair. Assemblies that have reached their design life are identified as current deficiencies and assigned the distress 'Beyond Useful Life'. The following chart lists all current deficiencies associated with this facility.

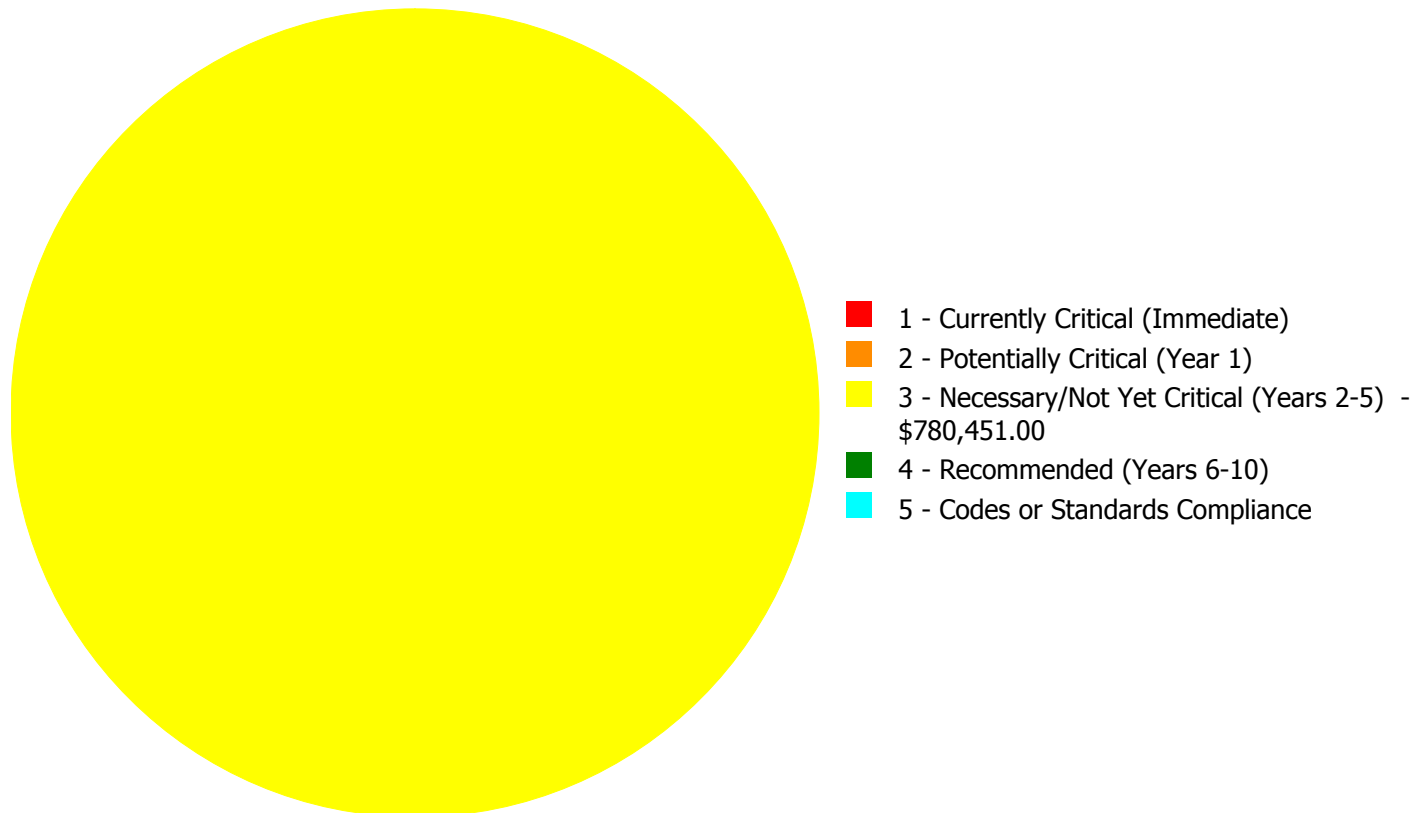
## Deficiency Summary by Priority

The following chart shows the total repair costs broken down by priority. Assessors assigned deficiencies within eCOMET to one of the following priority categories:

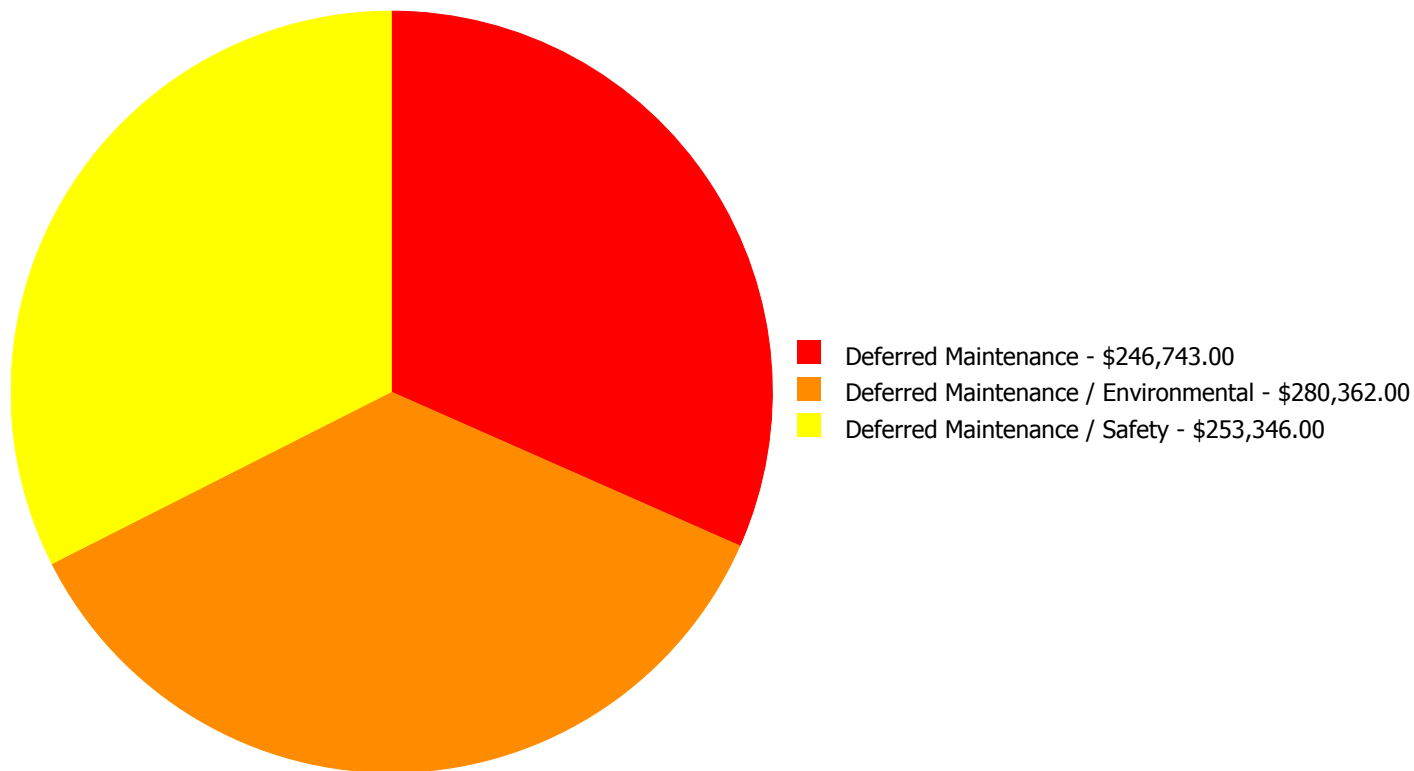
## Deficiency Summary by Category

The following chart shows the total repair costs broken down by deficiency categories. Assessors assigned deficiencies to one of the following categories:

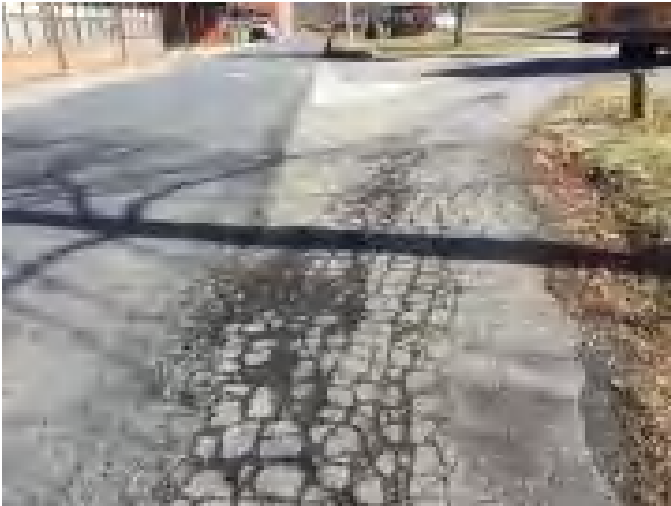
#### **System: G2010 - Roadways**

**Location:** Roadway  
**Distress:** Failing  
**Category:** Deferred Maintenance / Safety  
**Priority:** 3 - Necessary/Not Yet Critical (Years 2-5)  
**Correction:** Renew System  
**Qty:** 54,577.00  
**Unit of Measure:** S.F.  
**Estimate:** \$253,346.00  
**Assessor Name:** Matt Mahaffey  
**Date Created:** 02/01/2017

**Notes:** The asphaltic roadway is aged, has many road cuts and repairs, and should be re-surfaced.

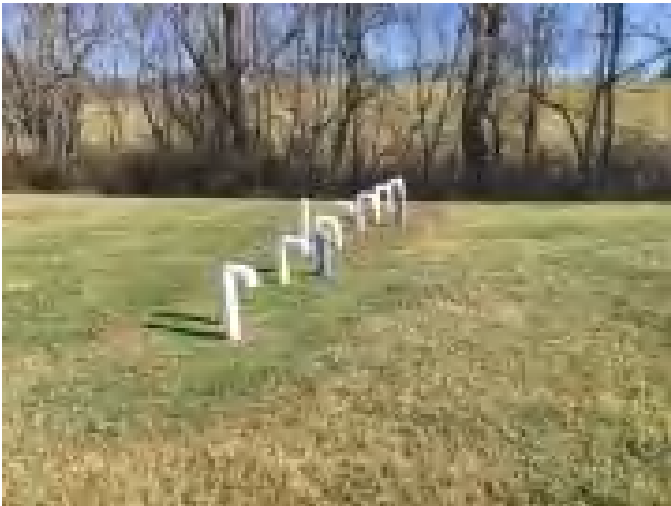
#### **System: G3020 - Sanitary Sewer**

**Location:** Septic  
**Distress:** Beyond Service Life  
**Category:** Deferred Maintenance  
**Priority:** 3 - Necessary/Not Yet Critical (Years 2-5)  
**Correction:** Renew System  
**Qty:** 54,577.00  
**Unit of Measure:** S.F.  
**Estimate:** \$91,253.00  
**Assessor Name:** Matt Mahaffey  
**Date Created:** 02/01/2017

**Notes:** The sanitary sewer system is aged, has reported periodic failures, and should be replaced.

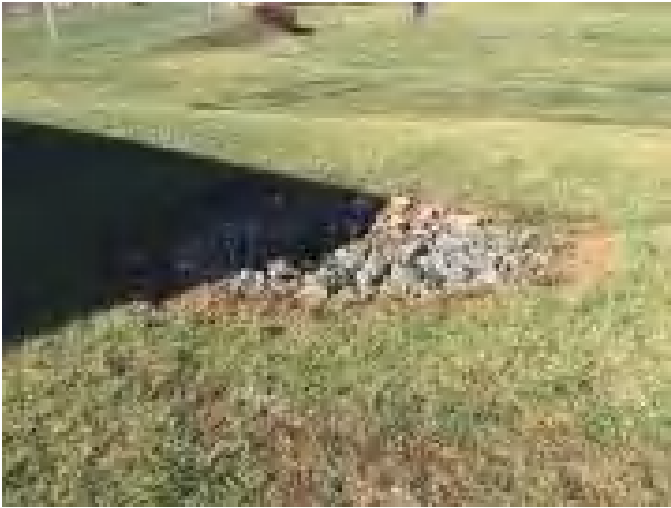
**System: G3030 - Storm Sewer**

**Location:** Throughout  
**Distress:** Inadequate  
**Category:** Deferred Maintenance / Environmental  
**Priority:** 3 - Necessary/Not Yet Critical (Years 2-5)  
**Correction:** Renew System  
**Qty:** 54,577.00  
**Unit of Measure:** S.F.  
**Estimate:** \$280,362.00  
**Assessor Name:** Matt Mahaffey  
**Date Created:** 02/01/2017

**Notes:** The storm sewer system does not adequately relieve site of storm water and should be improved or replaced.

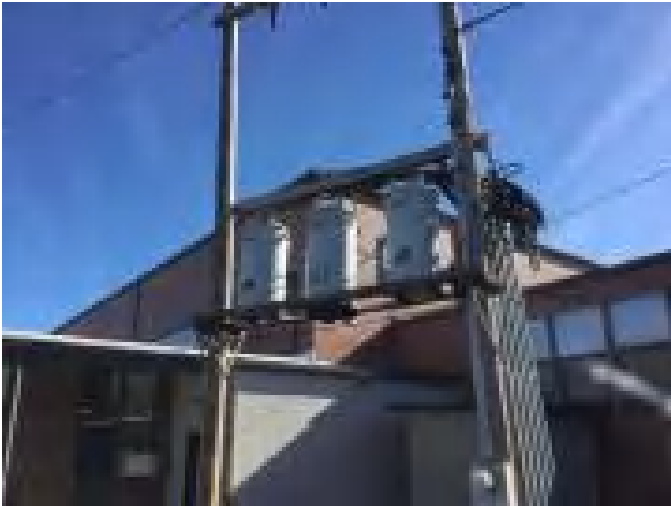
**System: G4010 - Electrical Distribution**

**Location:** Throughout  
**Distress:** Beyond Service Life  
**Category:** Deferred Maintenance  
**Priority:** 3 - Necessary/Not Yet Critical (Years 2-5)  
**Correction:** Renew System  
**Qty:** 54,577.00  
**Unit of Measure:** S.F.  
**Estimate:** \$155,490.00  
**Assessor Name:** Matt Mahaffey  
**Date Created:** 02/01/2017

**Notes:** The original electrical distribution system is operating properly due to an aggressive maintenance program but is aged, in marginal condition, and should be replaced.

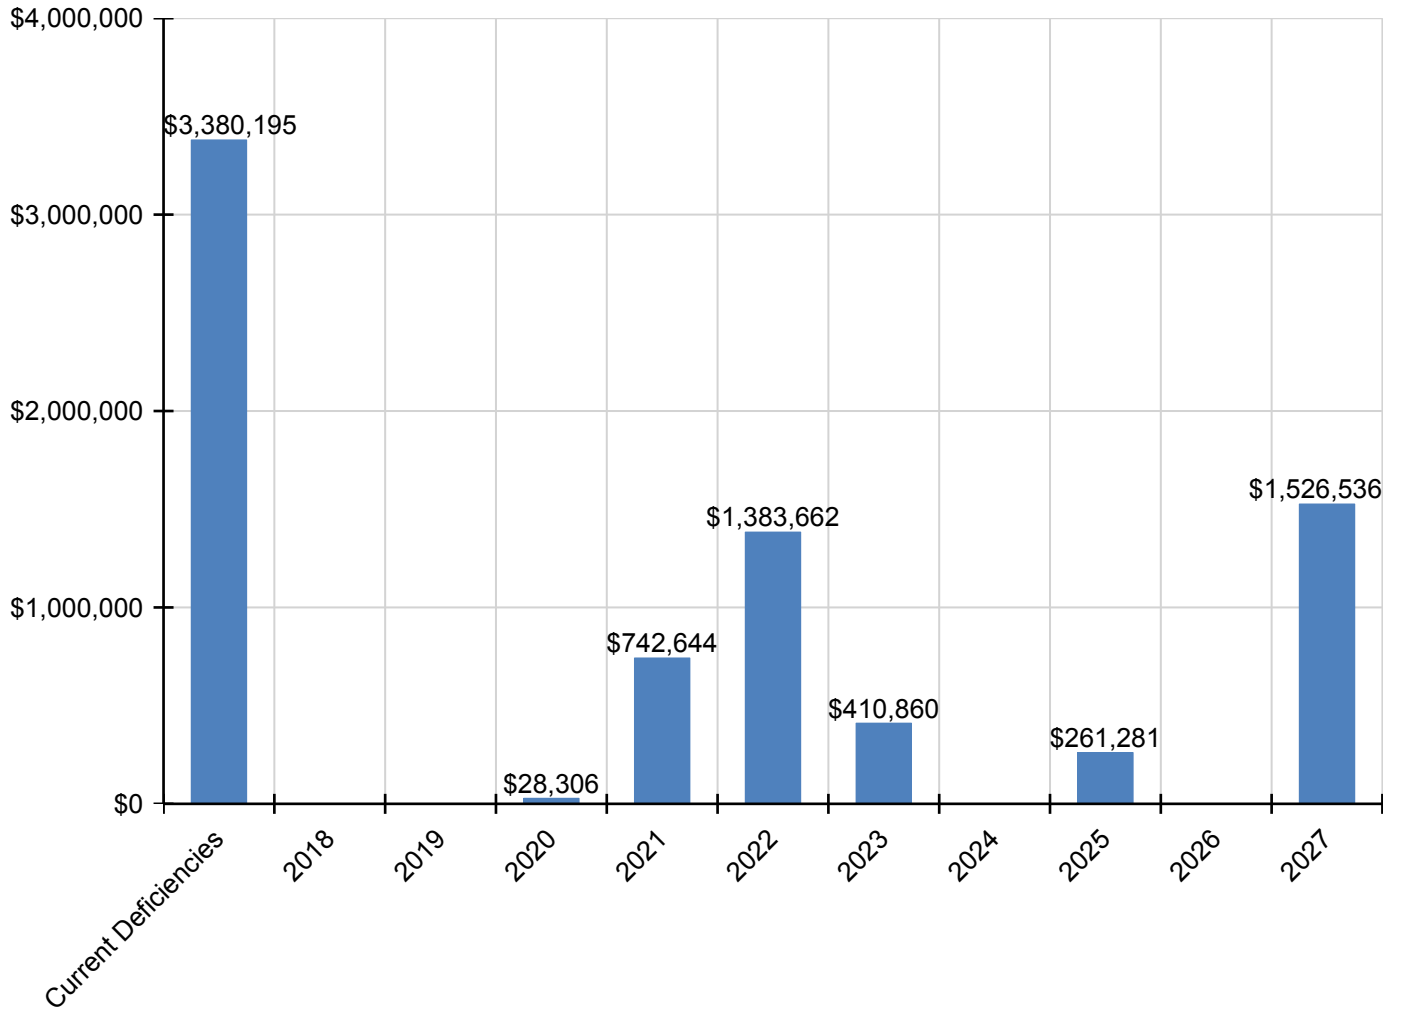
## Forecasted Capital Renewal Requirement

The following chart shows the current building deficiencies and forecasting capital renewal or sustainment requirements over the next ten years.

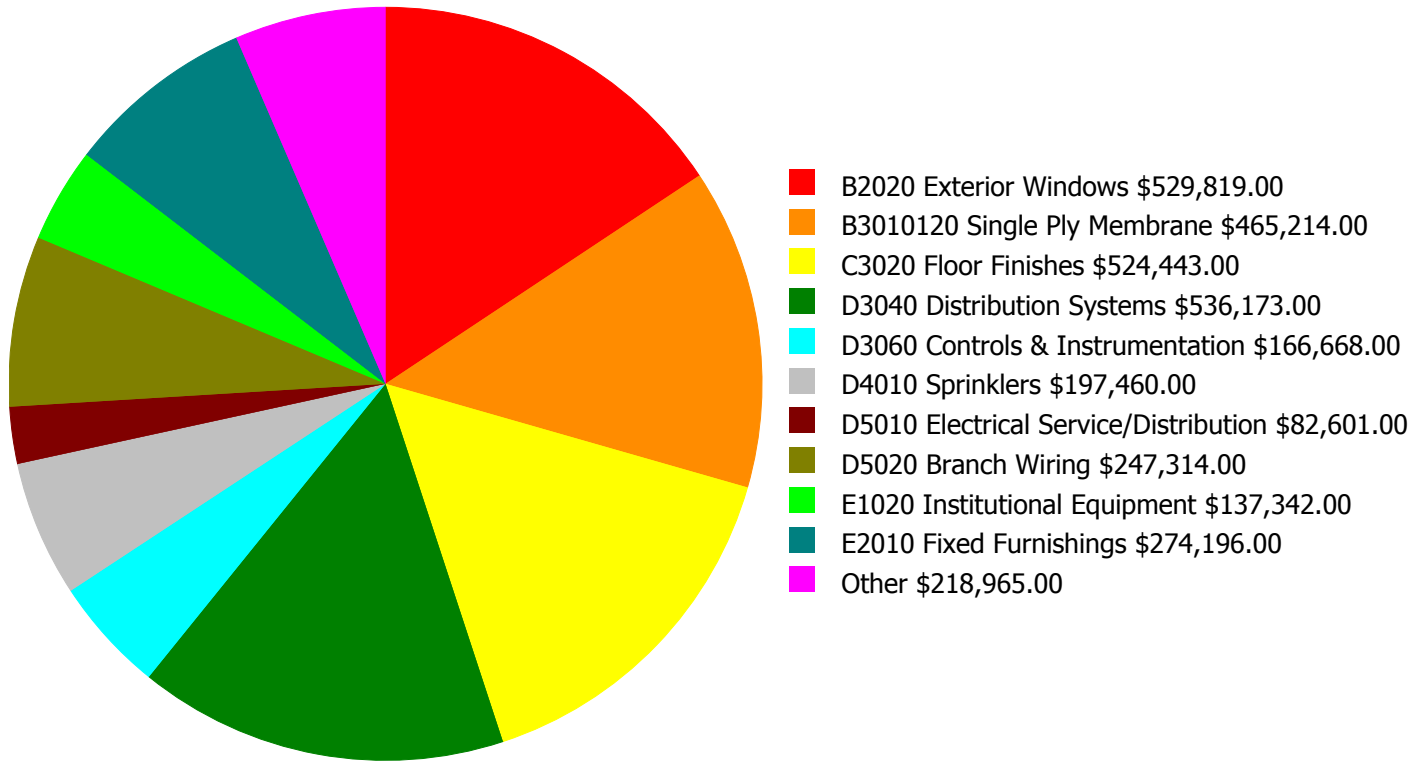
### Deficiency Summary by System

Current deficiencies included assemblies that have reached or exceeded their design life or components of the assemblies that are in need of repair. Assemblies that have reached their design life are identified as current deficiencies and assigned the distress 'Beyond Useful Life'. The following chart lists all current deficiencies associated with this facility.

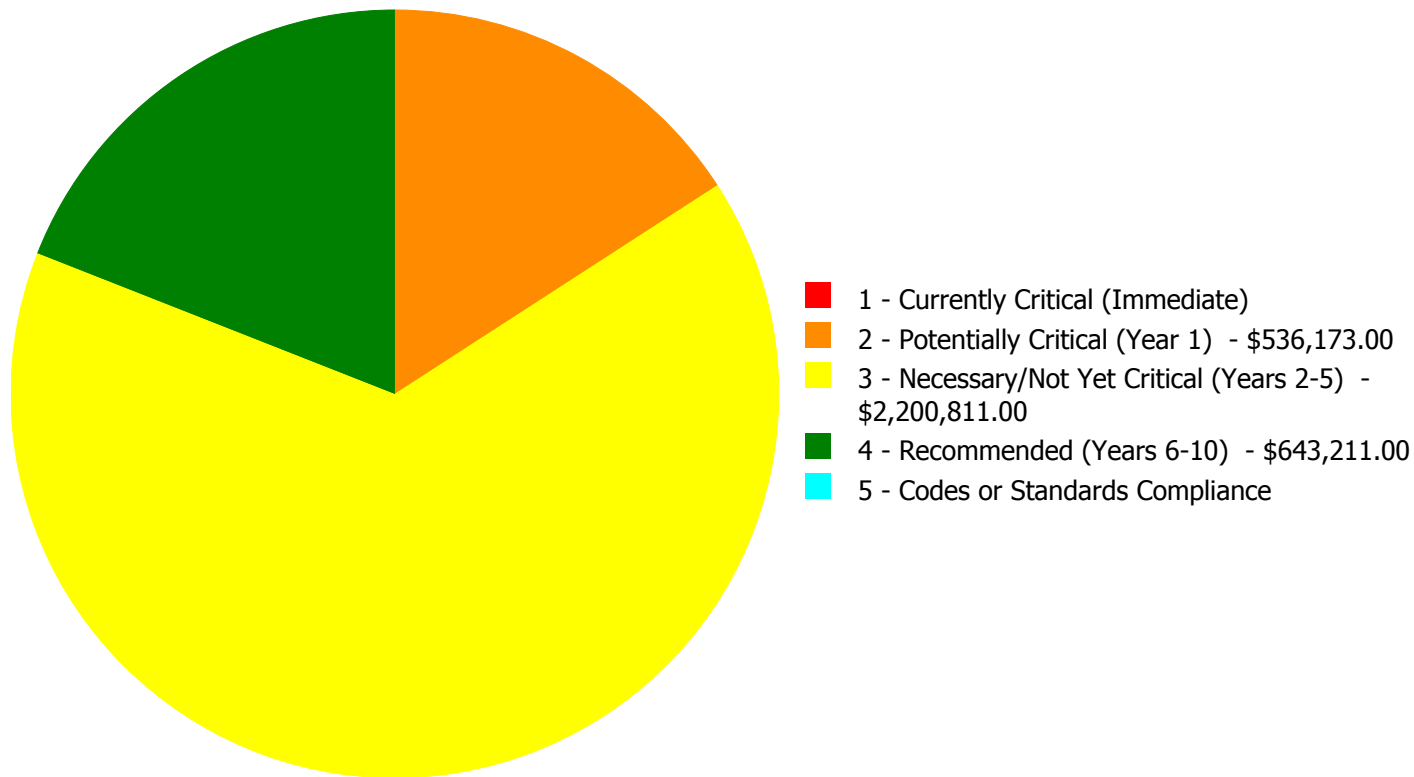
## Deficiency Summary by Priority

The following chart shows the total repair costs broken down by priority. Assessors assigned deficiencies within eCOMET to one of the following priority categories:
