NC School District/995 Yancey County/High School

# Mountain Heritage High

## Campus Assessment Report

March 7, 2017

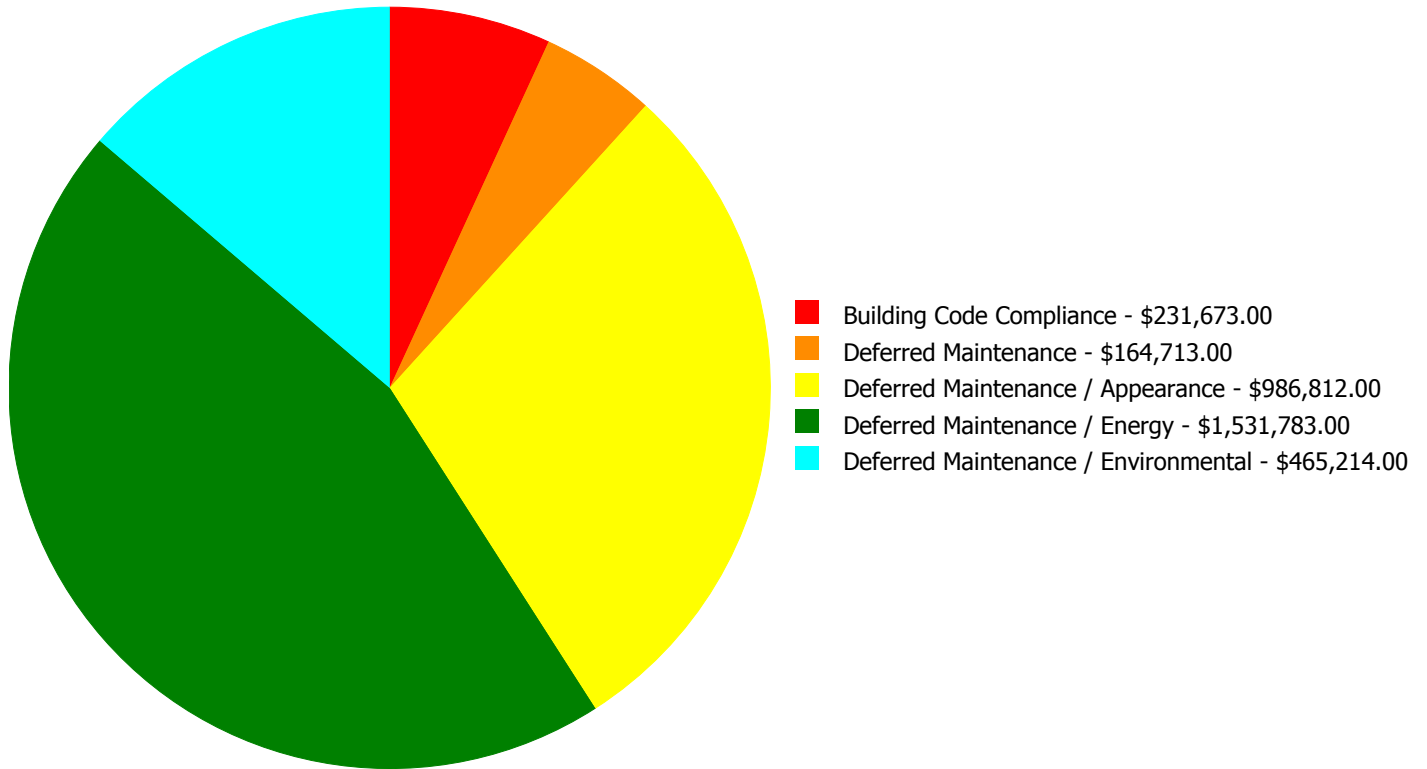
## Deficiency Summary by Category

The following chart shows the total repair costs broken down by deficiency categories. Assessors assigned deficiencies to one of the following categories:

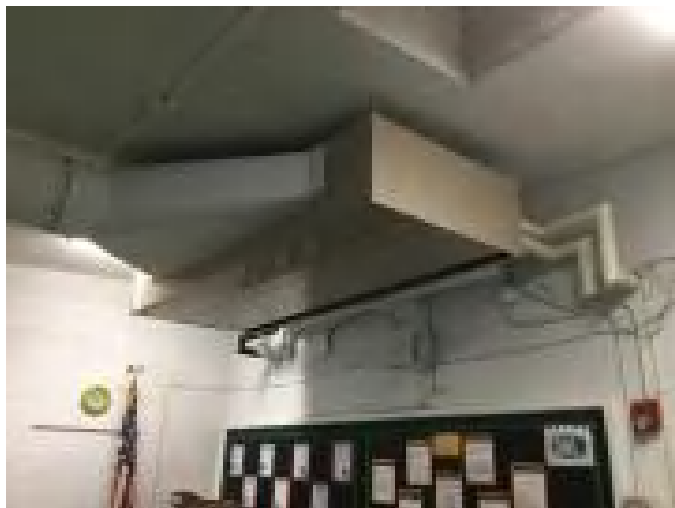
#### **System: D3040 - Distribution Systems**

**Location:** Throughout  
**Distress:** Failing  
**Category:** Deferred Maintenance / Energy  
**Priority:** 2 - Potentially Critical (Year 1)  
**Correction:** Renew System  
**Qty:** 44,433.00  
**Unit of Measure:** S.F.  
**Estimate:** \$536,173.00  
**Assessor Name:** Matt Mahaffey  
**Date Created:** 02/01/2017

**Notes:** The air distribution system is aged, becoming logistically unsupportable, and should be replaced.

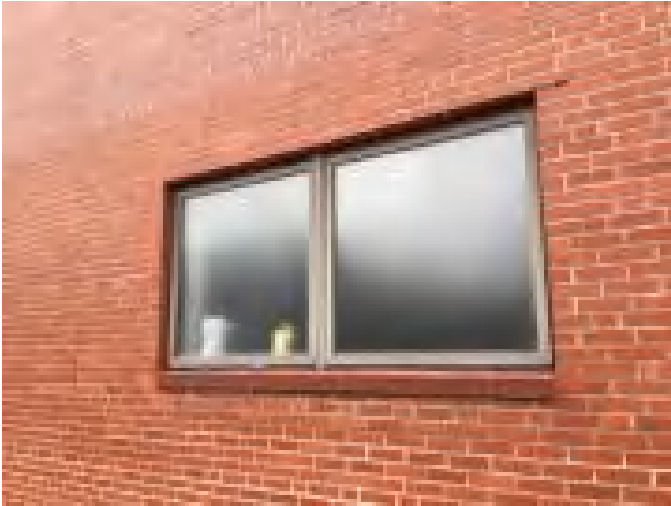
**System: B2020 - Exterior Windows**

**Location:** Throughout  
**Distress:** Beyond Service Life  
**Category:** Deferred Maintenance / Energy  
**Priority:** 3 - Necessary/Not Yet Critical (Years 2-5)  
**Correction:** Renew System  
**Qty:** 44,433.00  
**Unit of Measure:** S.F.  
**Estimate:** \$529,819.00  
**Assessor Name:** Matt Mahaffey  
**Date Created:** 02/01/2017

**Notes:** The aluminum frame, operable, single pane windows are aged, rusted, not energy efficient, and should be replaced.

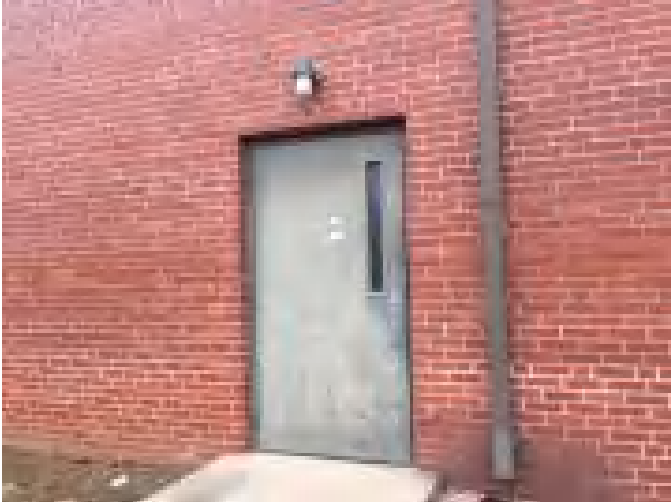
**System: B2030 - Exterior Doors**

**Location:** Throughout  
**Distress:** Beyond Service Life  
**Category:** Deferred Maintenance / Appearance  
**Priority:** 3 - Necessary/Not Yet Critical (Years 2-5)  
**Correction:** Renew System  
**Qty:** 44,433.00  
**Unit of Measure:** S.F.  
**Estimate:** \$50,831.00  
**Assessor Name:** Matt Mahaffey  
**Date Created:** 02/01/2017

**Notes:** The original exterior doors are aged, rusted, and should be replaced.

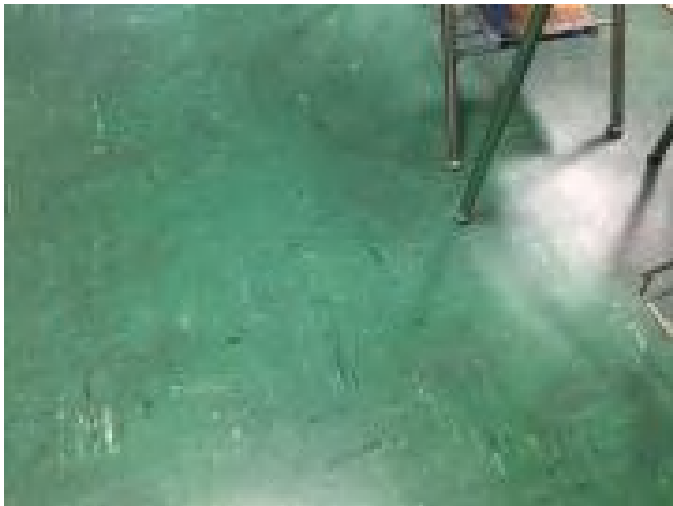
**System: C3020 - Floor Finishes**

**Location:** Throughout  
**Distress:** Beyond Service Life  
**Category:** Deferred Maintenance / Appearance  
**Priority:** 3 - Necessary/Not Yet Critical (Years 2-5)  
**Correction:** Renew System  
**Qty:** 44,433.00  
**Unit of Measure:** S.F.  
**Estimate:** \$524,443.00  
**Assessor Name:** Matt Mahaffey  
**Date Created:** 02/01/2017

**Notes:** The VCT flooring is aged, cracked, worn, and should be replaced.  
ACM tiles should be replaced where accessible.

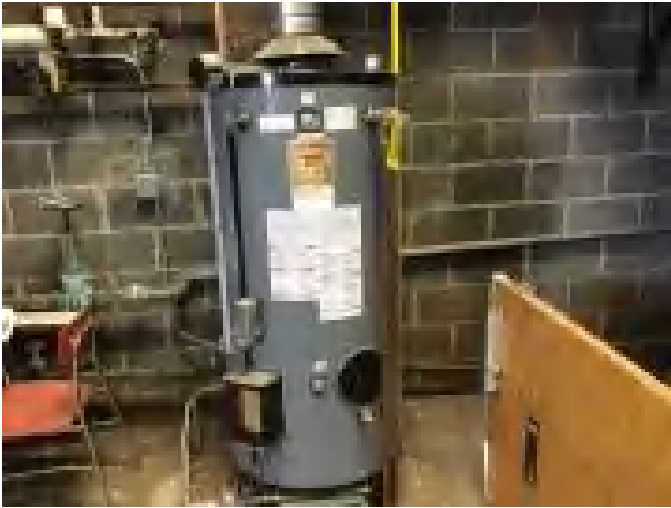
**System: D2020 - Domestic Water Distribution**

**Location:** Throughout  
**Distress:** Beyond Service Life  
**Category:** Deferred Maintenance / Energy  
**Priority:** 3 - Necessary/Not Yet Critical (Years 2-5)  
**Correction:** Renew System  
**Qty:** 44,433.00  
**Unit of Measure:** S.F.  
**Estimate:** \$51,809.00  
**Assessor Name:** Matt Mahaffey  
**Date Created:** 02/01/2017

**Notes:** The domestic water distribution system is aged and should be replaced.

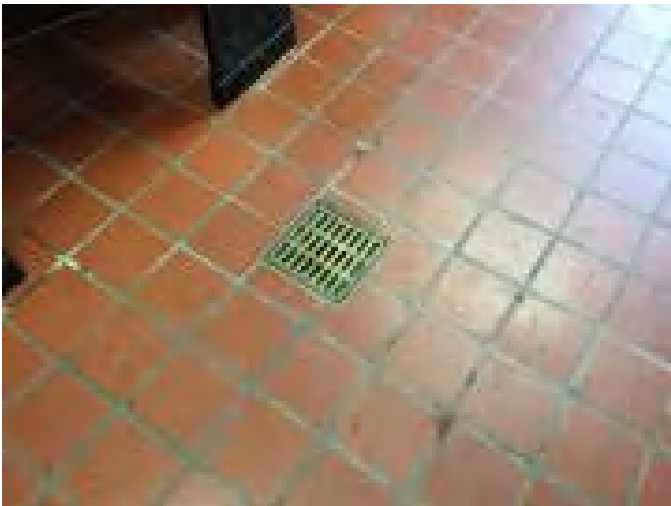
**System: D2030 - Sanitary Waste**

**Location:** Throughout  
**Distress:** Beyond Service Life  
**Category:** Deferred Maintenance  
**Priority:** 3 - Necessary/Not Yet Critical (Years 2-5)  
**Correction:** Renew System  
**Qty:** 44,433.00  
**Unit of Measure:** S.F.  
**Estimate:** \$82,112.00  
**Assessor Name:** Matt Mahaffey  
**Date Created:** 02/01/2017

**Notes:** The sanitary waste system is aged, has reported periodic failures, and should be replaced.

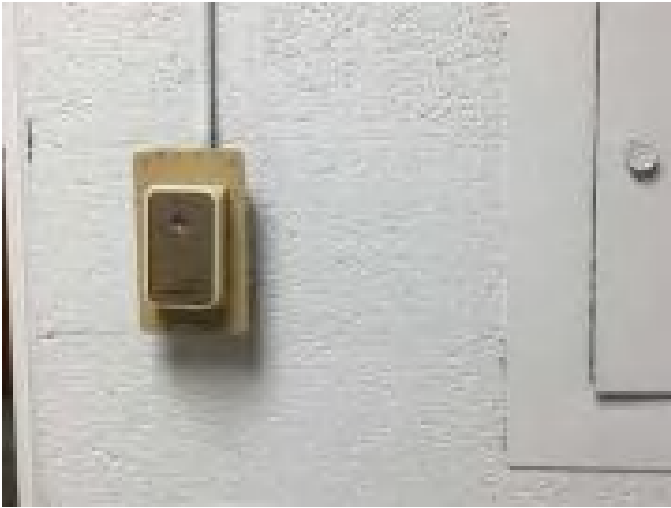
**System: D3060 - Controls & Instrumentation**

**Location:** Throughout  
**Distress:** Beyond Service Life  
**Category:** Deferred Maintenance / Energy  
**Priority:** 3 - Necessary/Not Yet Critical (Years 2-5)  
**Correction:** Renew System  
**Qty:** 44,433.00  
**Unit of Measure:** S.F.  
**Estimate:** \$166,668.00  
**Assessor Name:** Matt Mahaffey  
**Date Created:** 02/01/2017

**Notes:** The HVAC controls system is aged, becoming logistically unsupportable, and should be replaced.

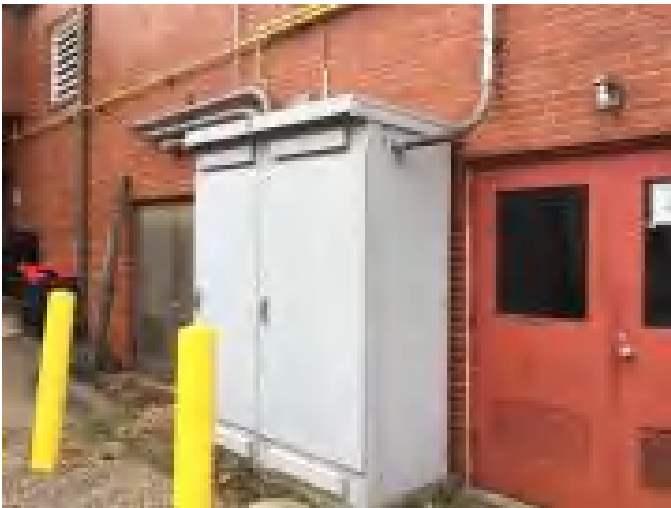
**System: D5010 - Electrical Service/Distribution**

**Location:** Throughout  
**Distress:** Beyond Service Life  
**Category:** Deferred Maintenance  
**Priority:** 3 - Necessary/Not Yet Critical (Years 2-5)  
**Correction:** Renew System  
**Qty:** 44,433.00  
**Unit of Measure:** S.F.  
**Estimate:** \$82,601.00  
**Assessor Name:** Matt Mahaffey  
**Date Created:** 02/01/2017

**Notes:** The original electrical distribution system is operating properly due to an aggressive maintenance program but is aged, in marginal condition, and should be replaced.

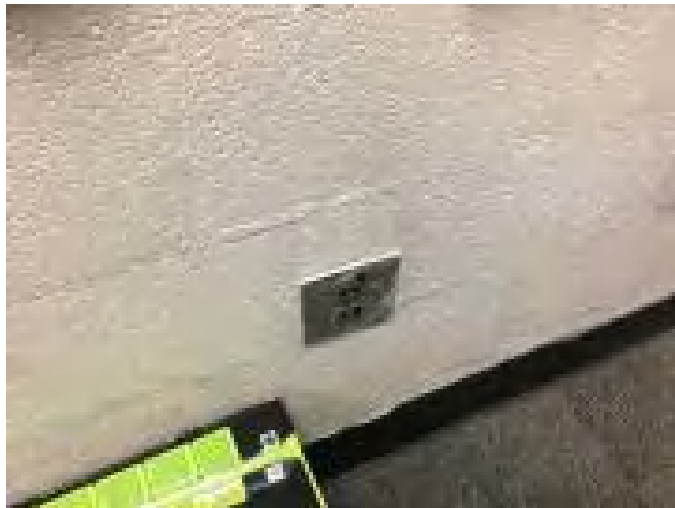
**System: D5020 - Branch Wiring**

**Location:** Throughout  
**Distress:** Beyond Service Life  
**Category:** Deferred Maintenance / Energy  
**Priority:** 3 - Necessary/Not Yet Critical (Years 2-5)  
**Correction:** Renew System  
**Qty:** 44,433.00  
**Unit of Measure:** S.F.  
**Estimate:** \$247,314.00  
**Assessor Name:** Matt Mahaffey  
**Date Created:** 02/01/2017

**Notes:** The original branch wiring system is operating, but is aged, in poor condition, and should be replaced.

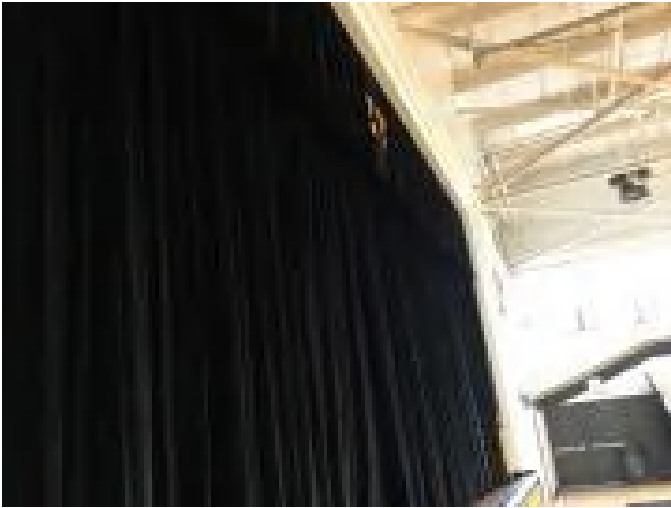
**System: E1020 - Institutional Equipment**

**Location:** Stage  
**Distress:** Beyond Service Life  
**Category:** Deferred Maintenance / Appearance  
**Priority:** 4 - Recommended (Years 6-10)  
**Correction:** Renew System  
**Qty:** 44,433.00  
**Unit of Measure:** S.F.  
**Estimate:** \$137,342.00  
**Assessor Name:** Matt Mahaffey  
**Date Created:** 02/01/2017

**Notes:** Theater and stage equipment is aged and should be replaced.

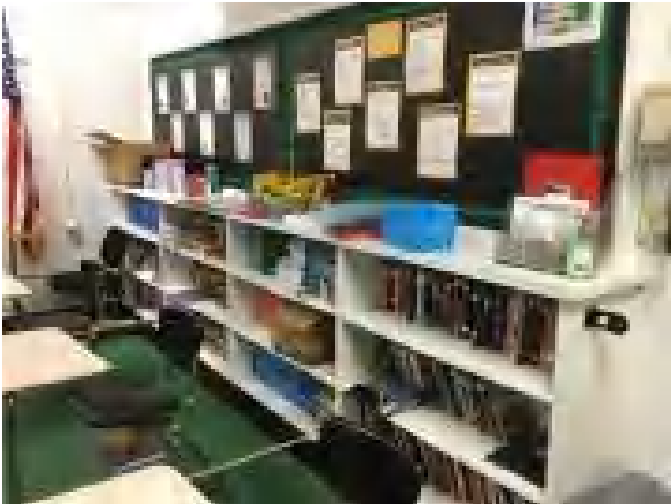
**System: E2010 - Fixed Furnishings**

**Location:** Throughout  
**Distress:** Beyond Service Life  
**Category:** Deferred Maintenance / Appearance  
**Priority:** 4 - Recommended (Years 6-10)  
**Correction:** Renew System  
**Qty:** 44,433.00  
**Unit of Measure:** S.F.  
**Estimate:** \$274,196.00  
**Assessor Name:** Matt Mahaffey  
**Date Created:** 02/01/2017

**Notes:** The fixed furnishings are aged, in marginal condition, and should be replaced.

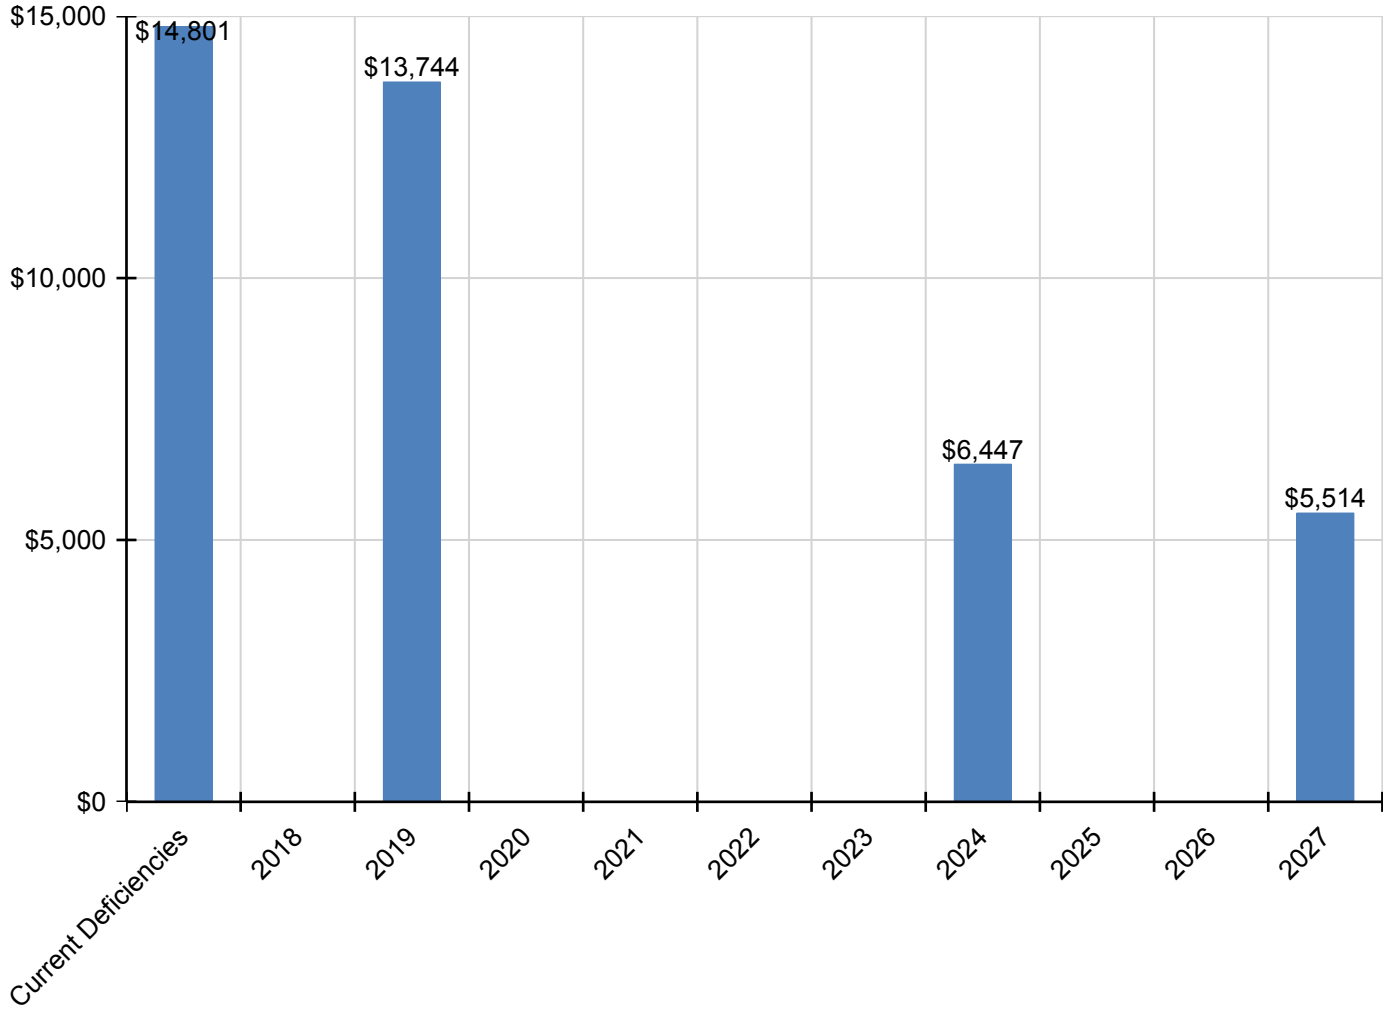
## Forecasted Capital Renewal Requirement

The following chart shows the current building deficiencies and forecasting capital renewal or sustainment requirements over the next ten years.

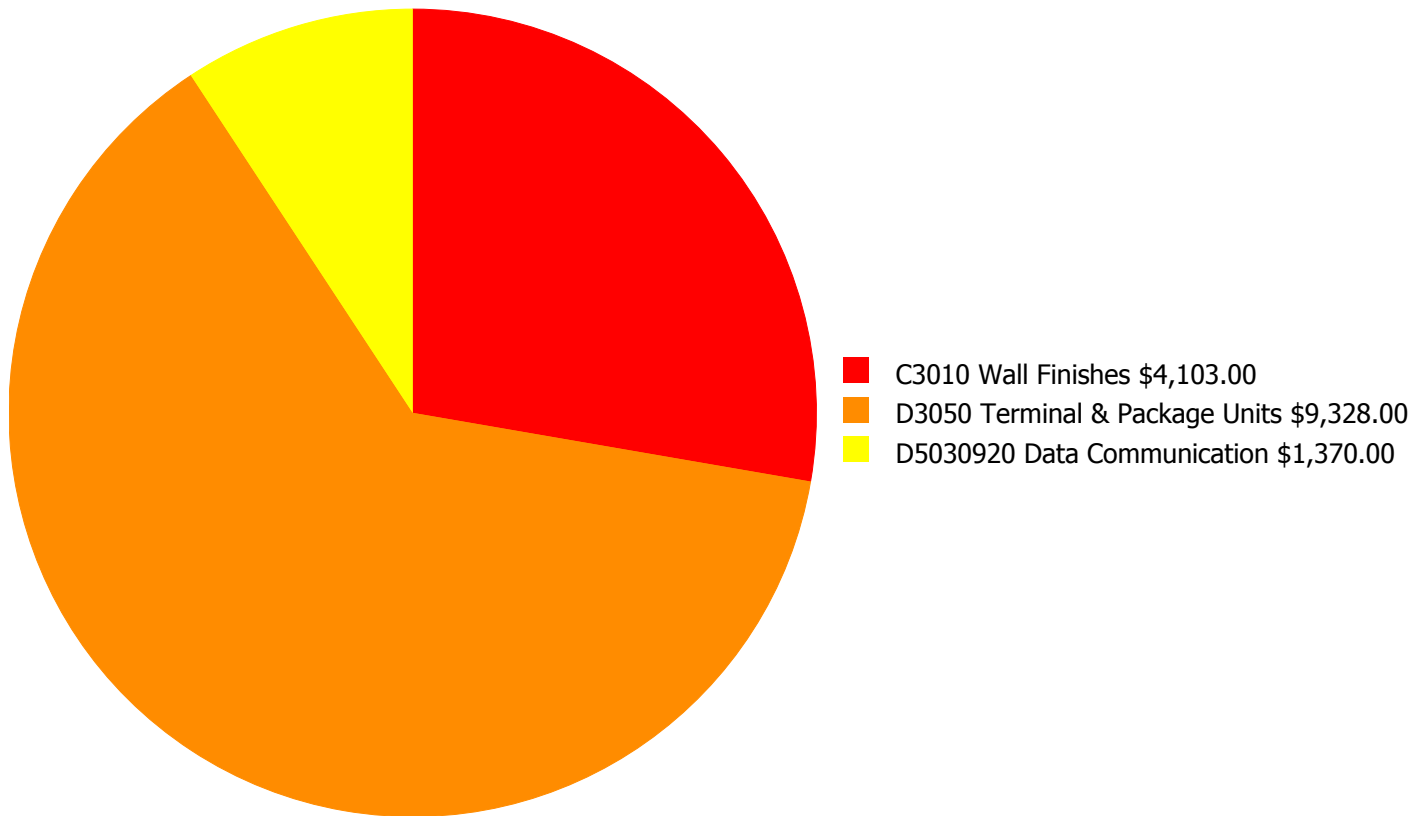
## Deficiency Summary by System

Current deficiencies included assemblies that have reached or exceeded their design life or components of the assemblies that are in need of repair. Assemblies that have reached their design life are identified as current deficiencies and assigned the distress 'Beyond Useful Life'. The following chart lists all current deficiencies associated with this facility.

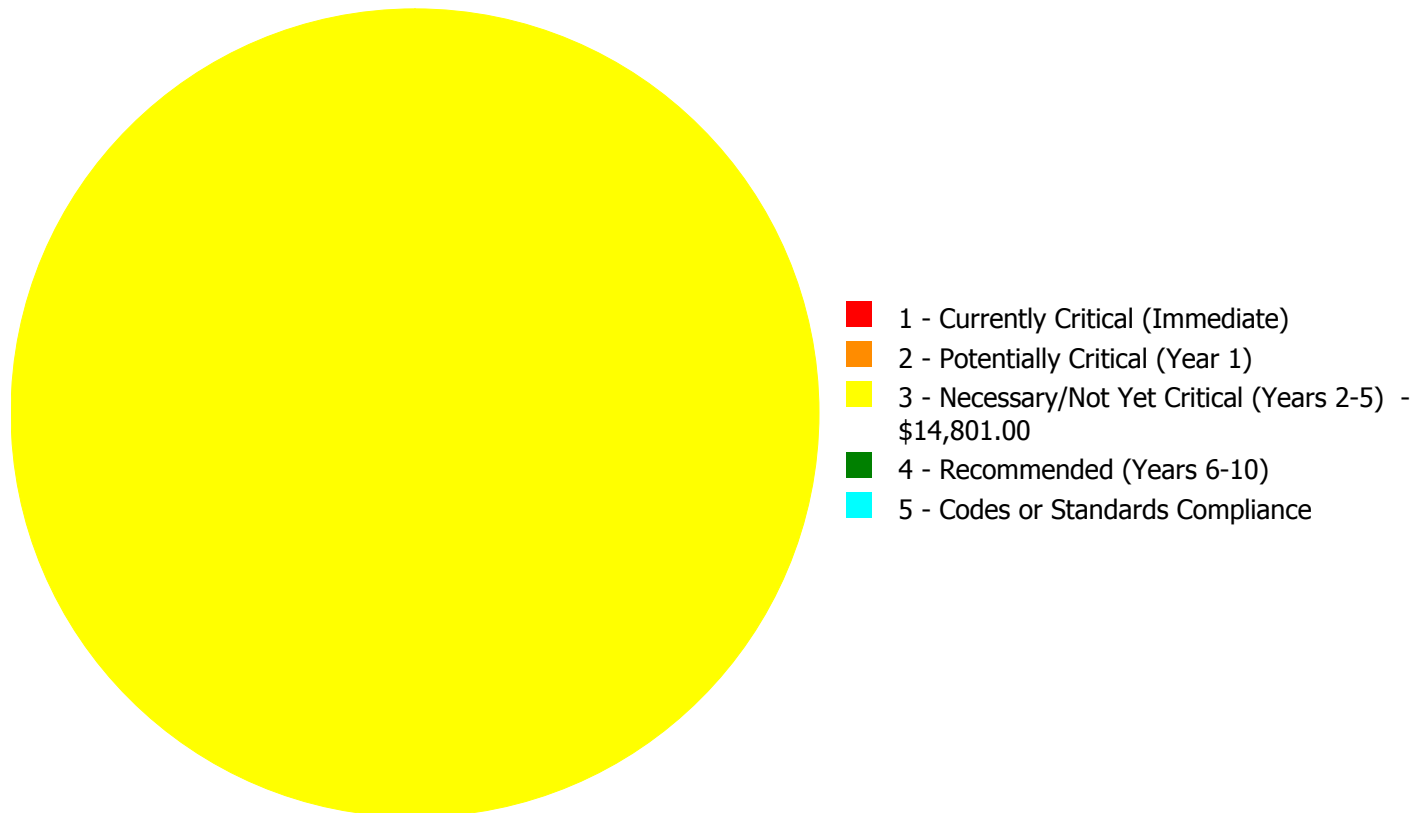
## Deficiency Summary by Priority

The following chart shows the total repair costs broken down by priority. Assessors assigned deficiencies within eCOMET to one of the following priority categories:

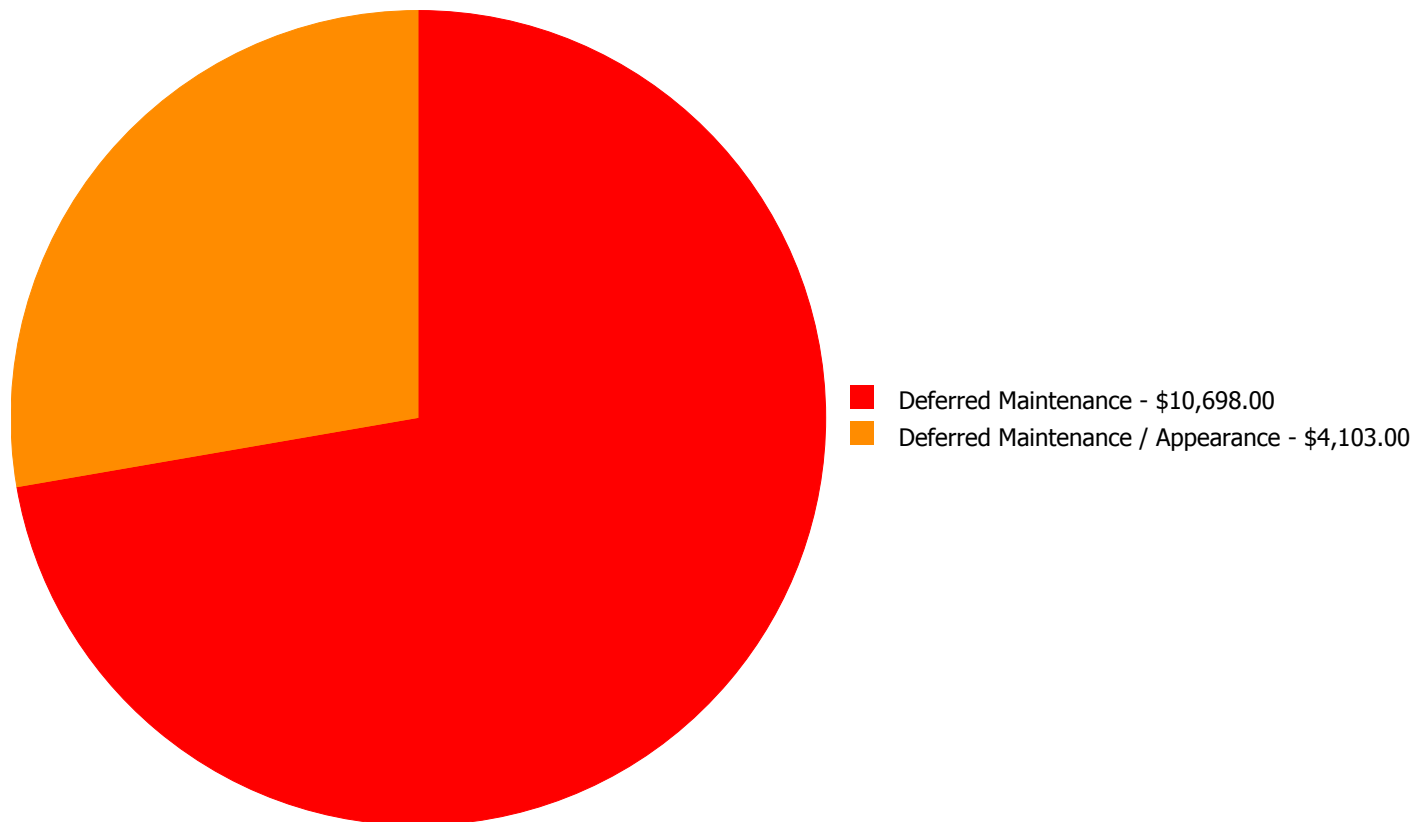
### Deficiency Summary by Category

The following chart shows the total repair costs broken down by deficiency categories. Assessors assigned deficiencies to one of the following categories:

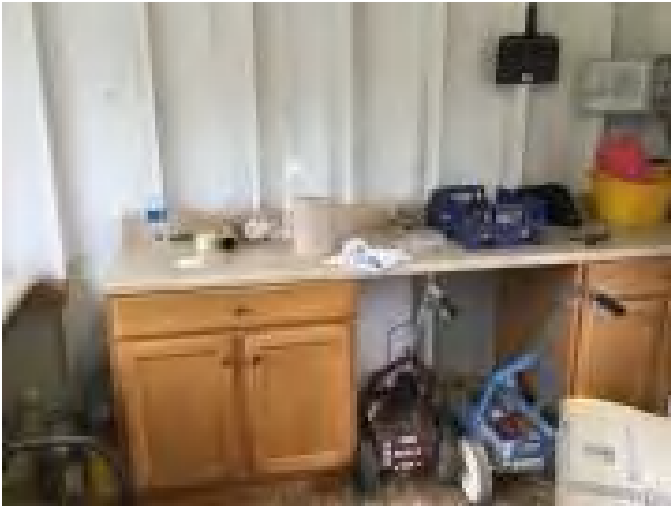
#### System: C3010 - Wall Finishes

**Location:** Throughout  
**Distress:** Beyond Service Life  
**Category:** Deferred Maintenance / Appearance  
**Priority:** 3 - Necessary/Not Yet Critical (Years 2-5)  
**Correction:** Renew System  
**Qty:** 500.00  
**Unit of Measure:** S.F.  
**Estimate:** \$4,103.00  
**Assessor Name:** Eduardo Lopez  
**Date Created:** 02/01/2017

**Notes:** The wall paint is damaged, fading, stained, and should be re-painted.

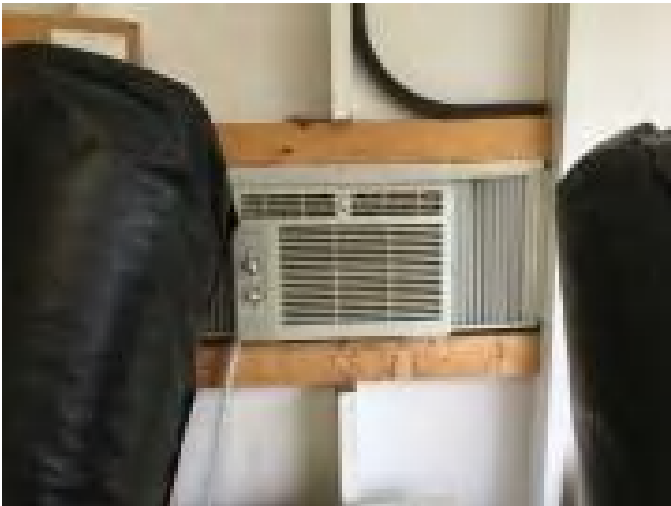
#### System: D3050 - Terminal & Package Units

**Location:** Throughout  
**Distress:** Beyond Service Life  
**Category:** Deferred Maintenance  
**Priority:** 3 - Necessary/Not Yet Critical (Years 2-5)  
**Correction:** Renew System  
**Qty:** 500.00  
**Unit of Measure:** S.F.  
**Estimate:** \$9,328.00  
**Assessor Name:** Eduardo Lopez  
**Date Created:** 02/01/2017

**Notes:** The wall mounted DX condensers are aged, rusted, not energy efficient, and should be replaced.

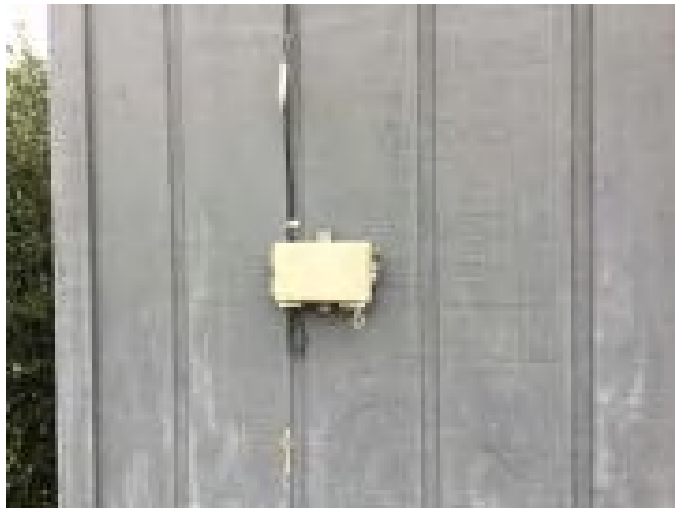
**System: D5030920 - Data Communication**

**Location:** Throughout  
**Distress:** Failing  
**Category:** Deferred Maintenance  
**Priority:** 3 - Necessary/Not Yet Critical (Years 2-5)  
**Correction:** Renew System  
**Qty:** 500.00  
**Unit of Measure:** S.F.  
**Estimate:** \$1,370.00  
**Assessor Name:** Eduardo Lopez  
**Date Created:** 02/01/2017

**Notes:** The data communication system is failing and should be replaced.

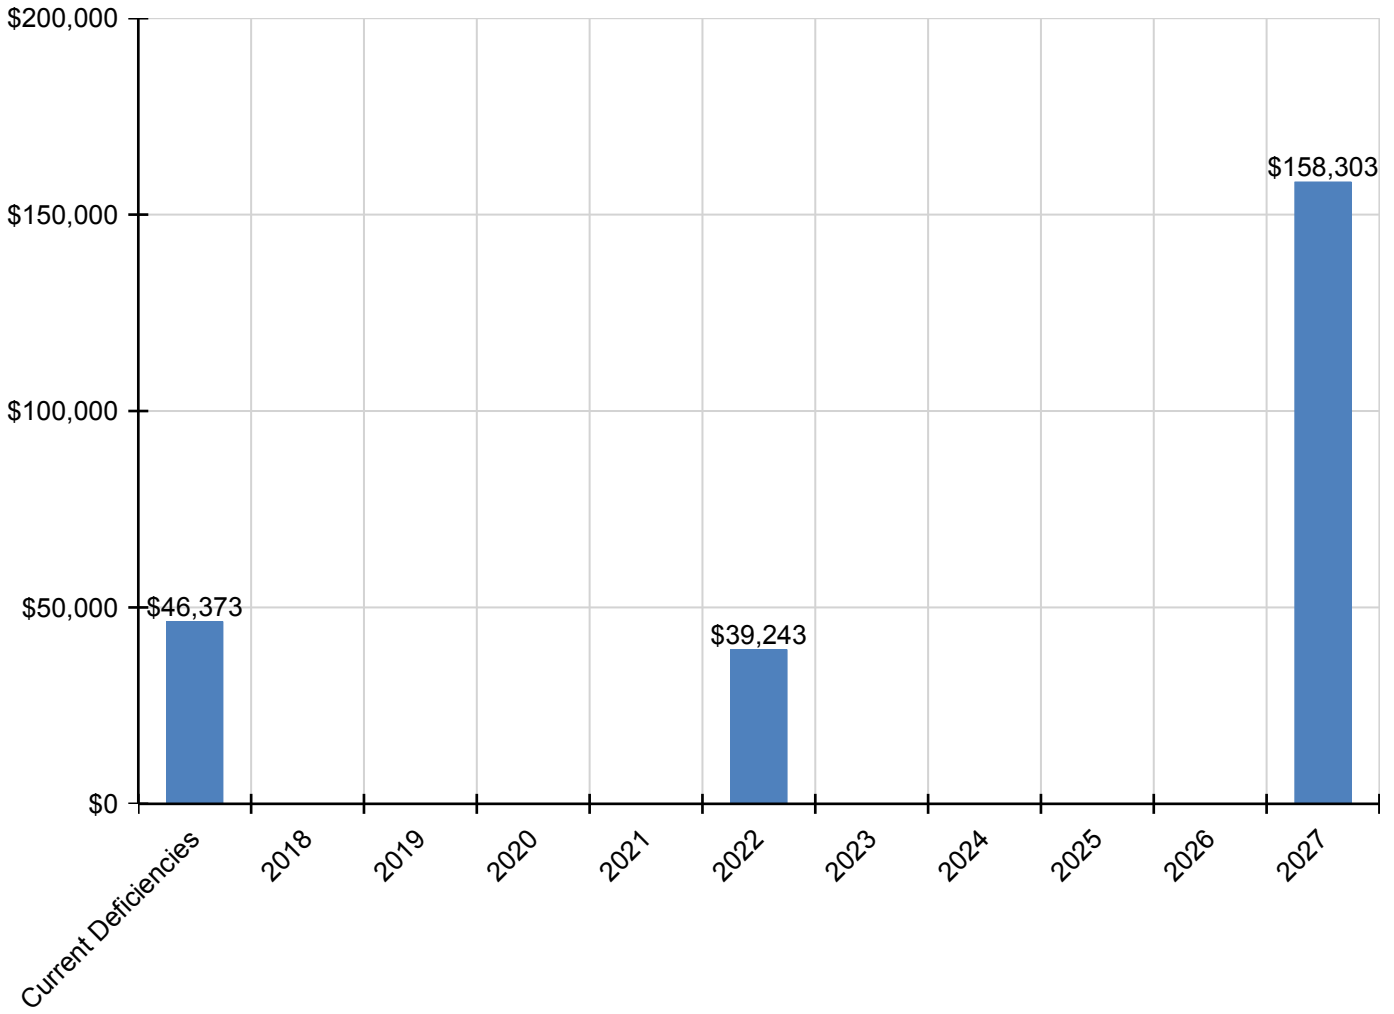
## Forecasted Capital Renewal Requirement

The following chart shows the current building deficiencies and forecasting capital renewal or sustainment requirements over the next ten years.

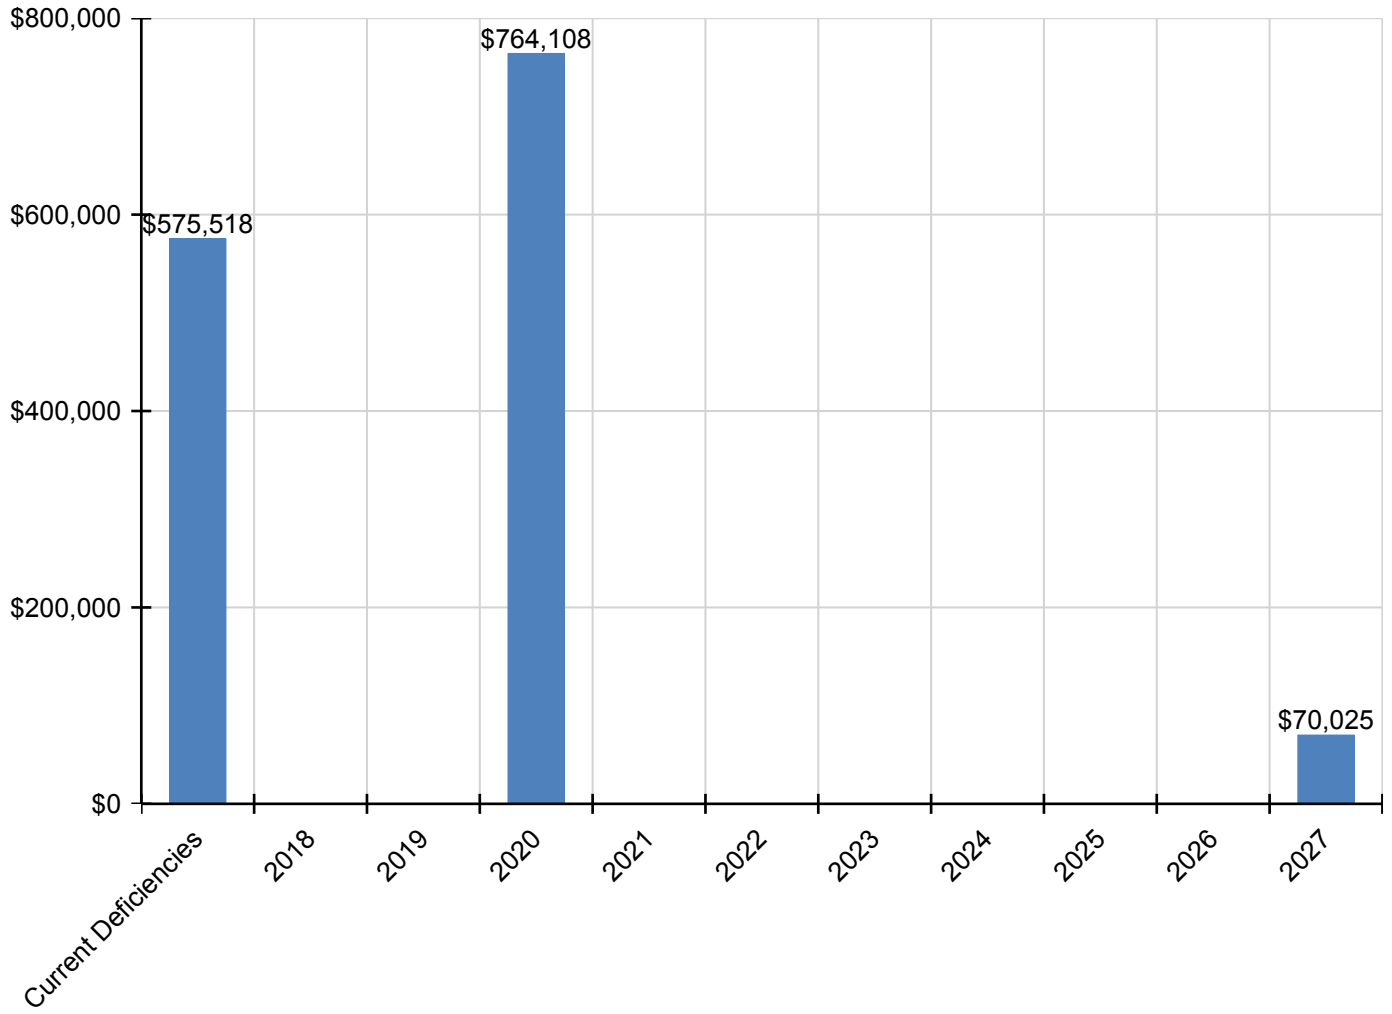
## Forecasted Capital Renewal Requirement

The following chart shows the current building deficiencies and forecasting capital renewal or sustainment requirements over the next ten years.

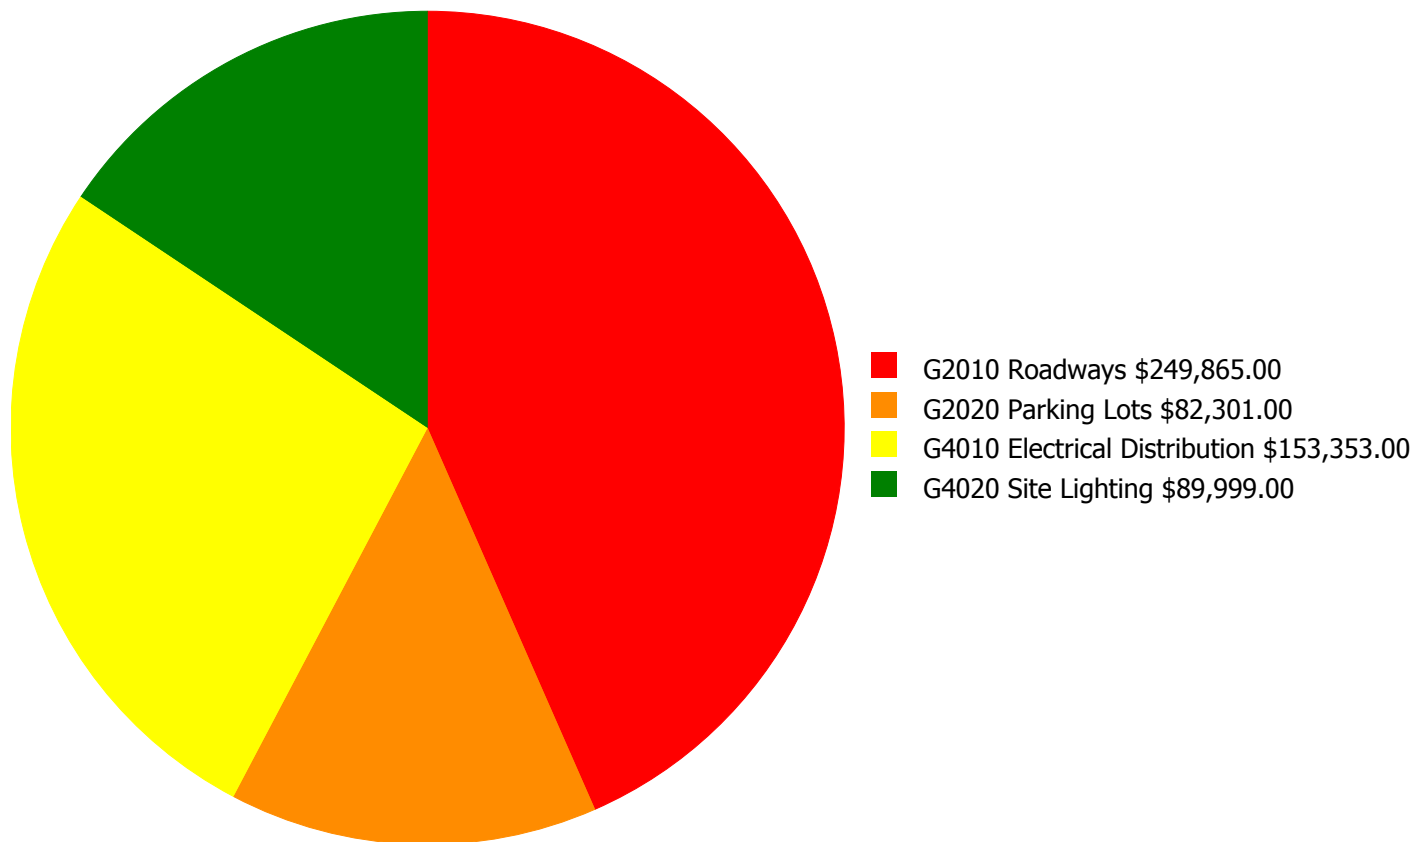
## Deficiency Summary by System

Current deficiencies included assemblies that have reached or exceeded their design life or components of the assemblies that are in need of repair. Assemblies that have reached their design life are identified as current deficiencies and assigned the distress 'Beyond Useful Life'. The following chart lists all current deficiencies associated with this facility.

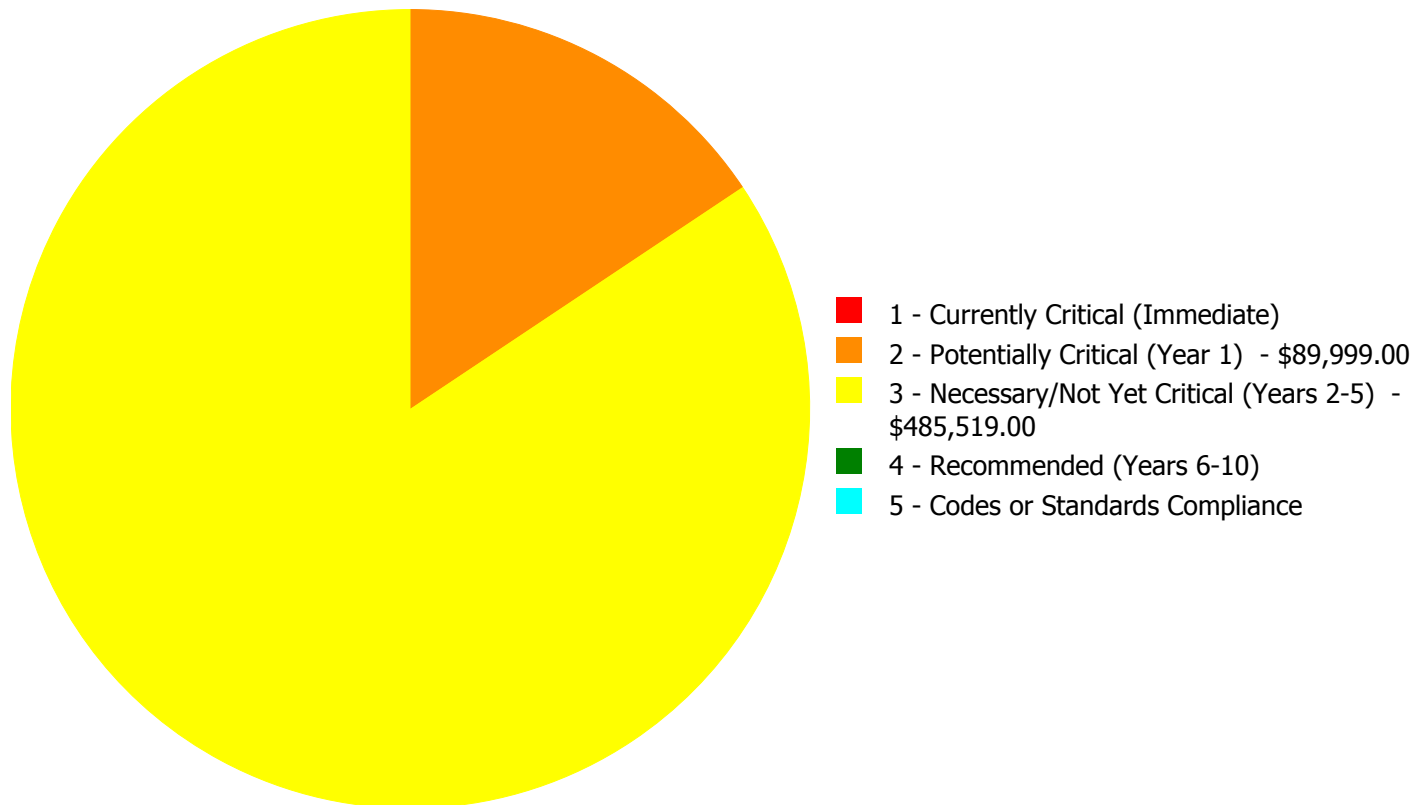
## Deficiency Summary by Priority

The following chart shows the total repair costs broken down by priority. Assessors assigned deficiencies within eCOMET to one of the following priority categories:

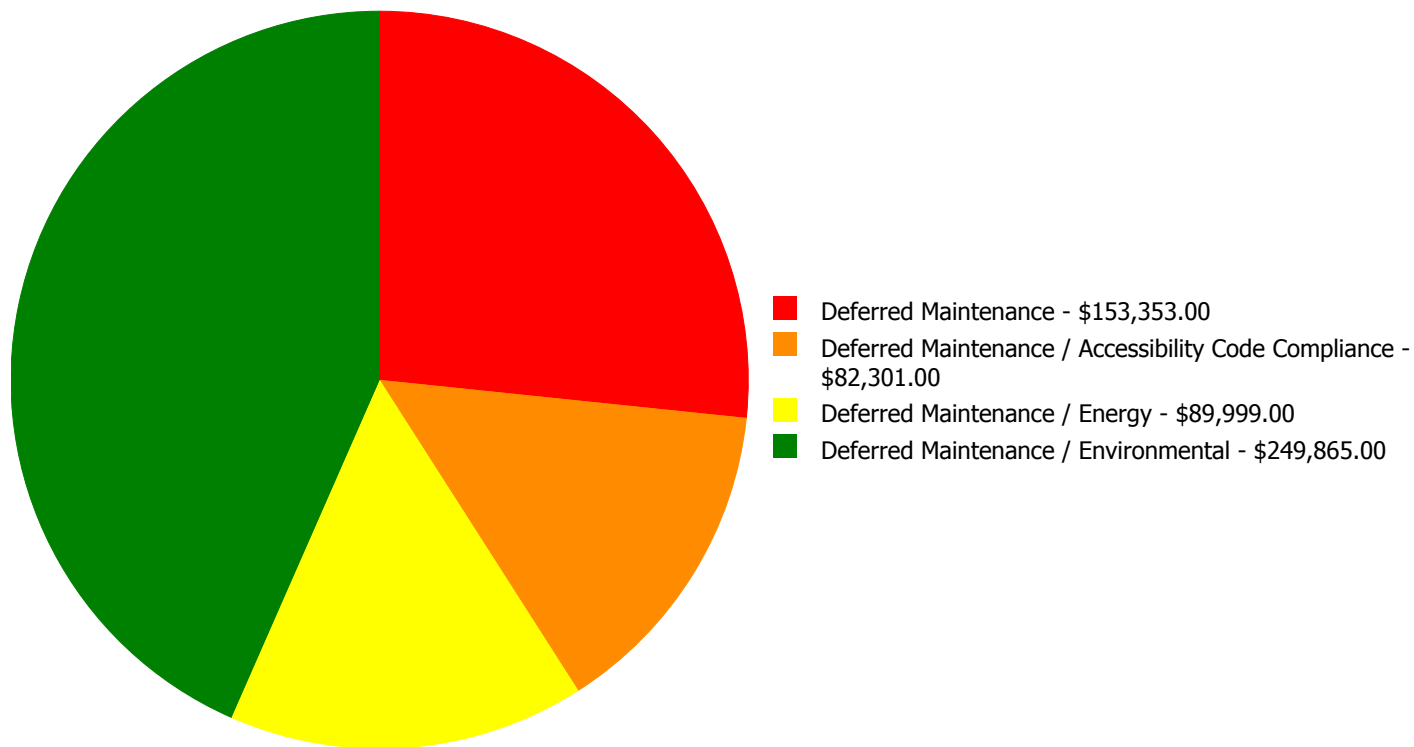
## Deficiency Summary by Category

The following chart shows the total repair costs broken down by deficiency categories. Assessors assigned deficiencies to one of the following categories:

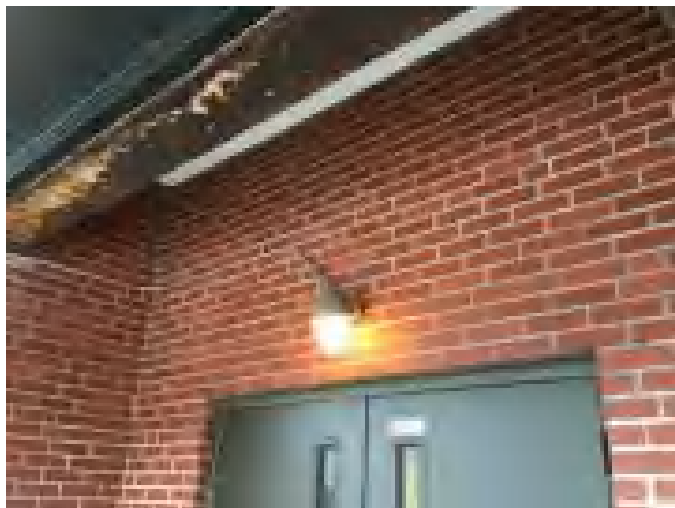
#### **System: G4020 - Site Lighting**

**Location:** Site  
**Distress:** Beyond Service Life  
**Category:** Deferred Maintenance / Energy  
**Priority:** 2 - Potentially Critical (Year 1)  
**Correction:** Renew System  
**Qty:** 53,827.00  
**Unit of Measure:** S.F.  
**Estimate:** \$89,999.00  
**Assessor Name:** Eduardo Lopez  
**Date Created:** 02/01/2017

**Notes:** The original site lighting system is operating, but is aged, in poor condition, and should be replaced.

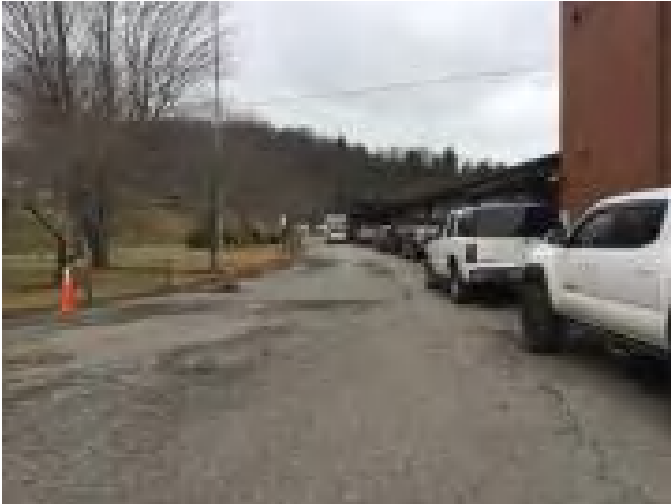
**System: G2010 - Roadways**

**Location:** Roadway  
**Distress:** Beyond Service Life  
**Category:** Deferred Maintenance / Environmental  
**Priority:** 3 - Necessary/Not Yet Critical (Years 2-5)  
**Correction:** Renew System  
**Qty:** 53,827.00  
**Unit of Measure:** S.F.  
**Estimate:** \$249,865.00  
**Assessor Name:** Eduardo Lopez  
**Date Created:** 02/01/2017

**Notes:** The asphaltic roadway is aged, has many road cuts and repairs, and should be re-surfaced.

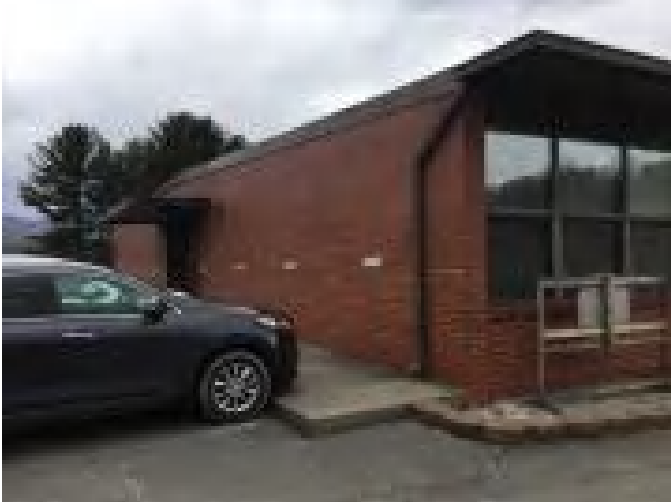
**System: G2020 - Parking Lots**

**Location:** Parking  
**Distress:** Beyond Service Life  
**Category:** Deferred Maintenance / Accessibility Code Compliance  
**Priority:** 3 - Necessary/Not Yet Critical (Years 2-5)  
**Correction:** Renew System  
**Qty:** 53,827.00  
**Unit of Measure:** S.F.  
**Estimate:** \$82,301.00  
**Assessor Name:** Eduardo Lopez  
**Date Created:** 02/01/2017

**Notes:** The parking lot is aged, has many repairs and potholes, and should be replaced and re-striped. ADA signs height needs to be adjusted per minimum ADA standards.

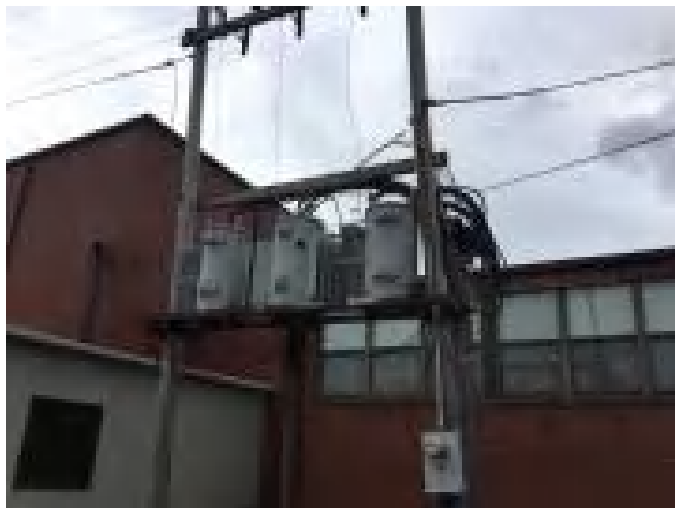
**System: G4010 - Electrical Distribution**

**Location:** Site  
**Distress:** Beyond Service Life  
**Category:** Deferred Maintenance  
**Priority:** 3 - Necessary/Not Yet Critical (Years 2-5)  
**Correction:** Renew System  
**Qty:** 53,827.00  
**Unit of Measure:** S.F.  
**Estimate:** \$153,353.00  
**Assessor Name:** Eduardo Lopez  
**Date Created:** 02/01/2017

**Notes:** The original electrical distribution system is operating properly due to an aggressive maintenance program but is aged, in marginal condition, and should be replaced.

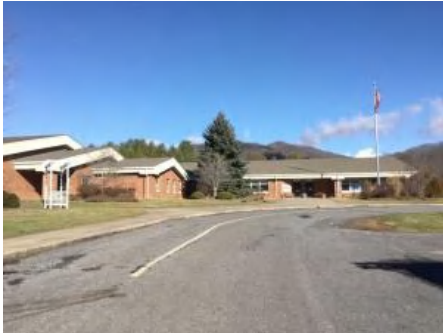
1). South Elevation - Feb 01, 2017

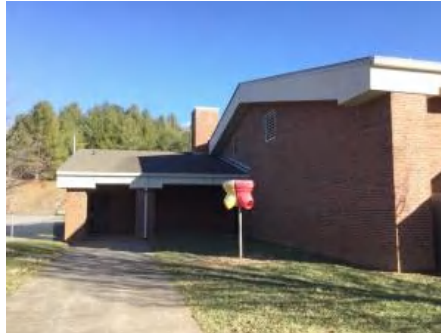
2). East Elevation - Feb 01, 2017

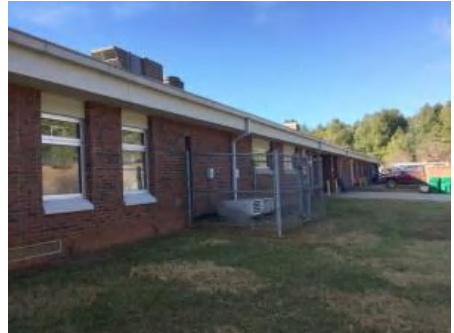
3). North Elevation - Feb 01, 2017

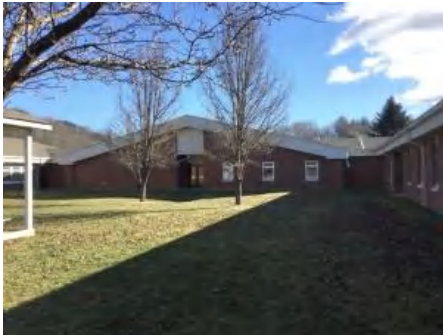
4). West Elevation - Feb 01, 2017

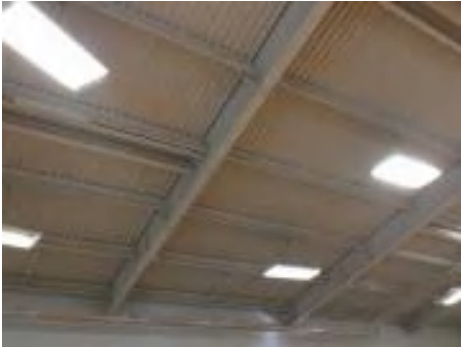
**System:** B1020 - Roof Construction

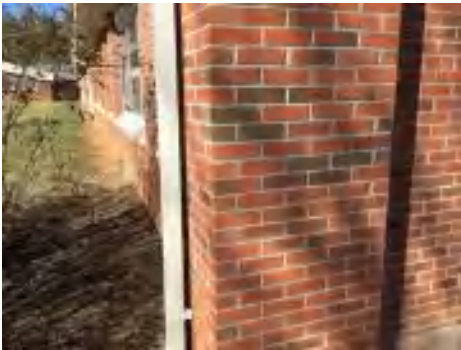
**System:** B2010 - Exterior Walls

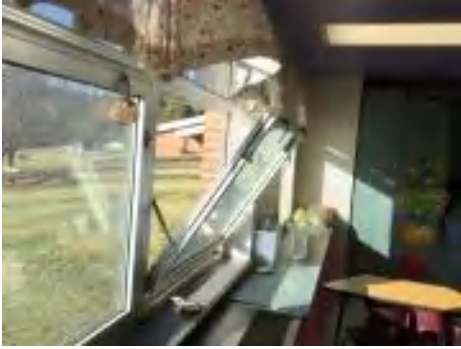
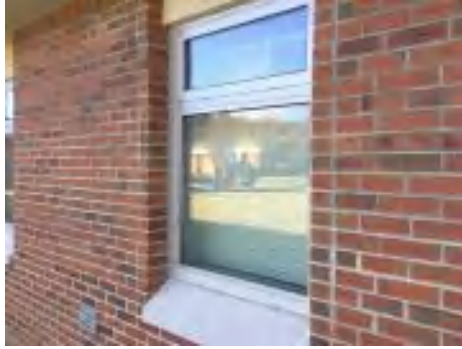
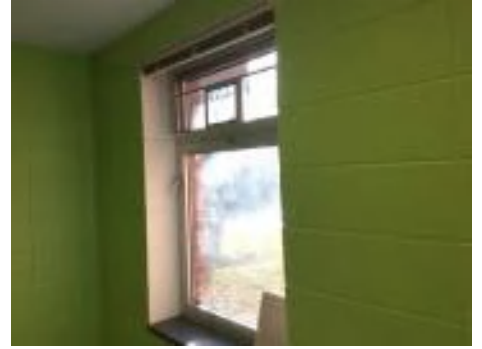
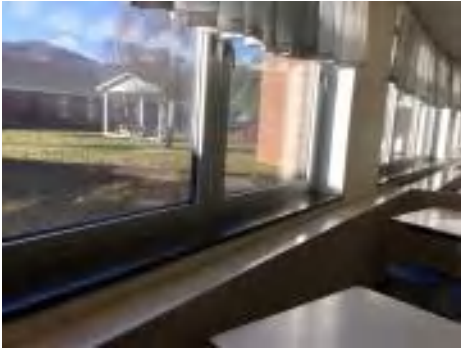
**System:** B2020 - Exterior Windows
