NC School District/995 Yancey County/High School

# Mountain Heritage High

## Campus Assessment Report

March 7, 2017

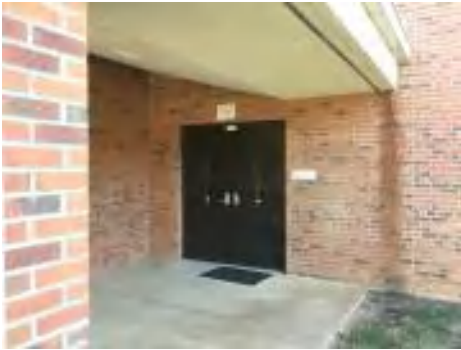
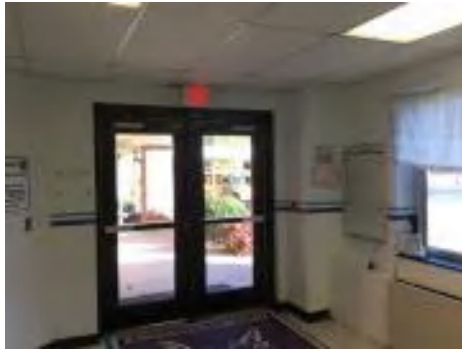
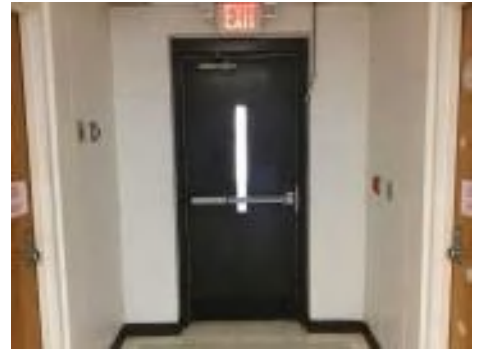
**System:** B2030 - Exterior Doors

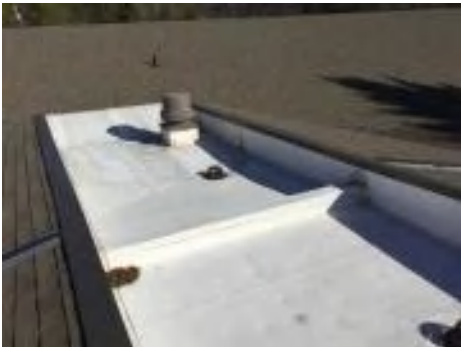
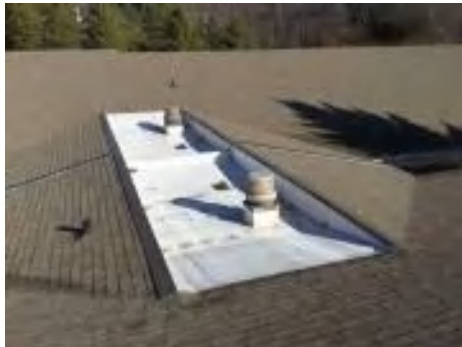
**System:** B3010120 - Single Ply Membrane

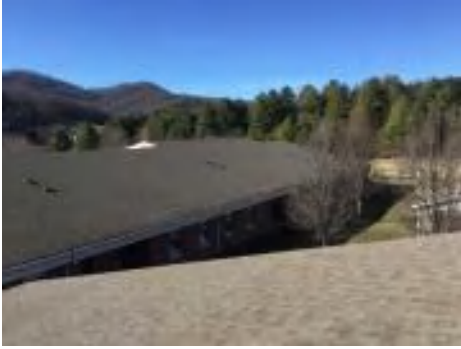
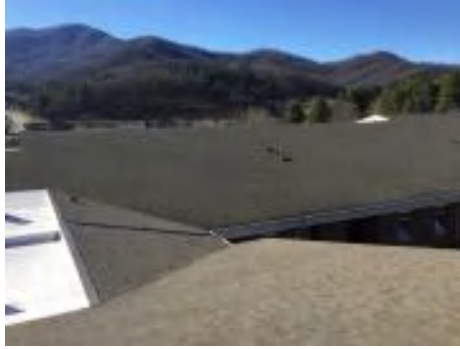
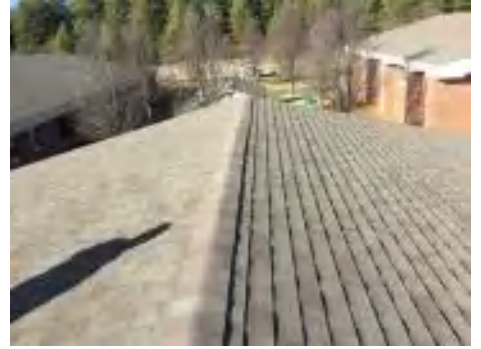
**System:** B3010140 - Asphalt Shingles

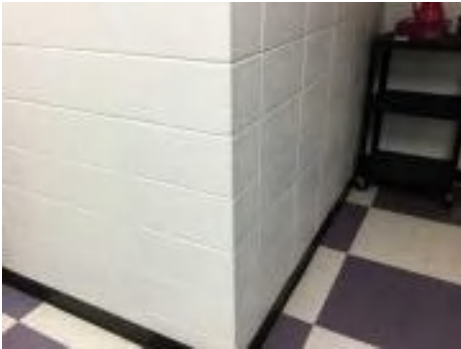
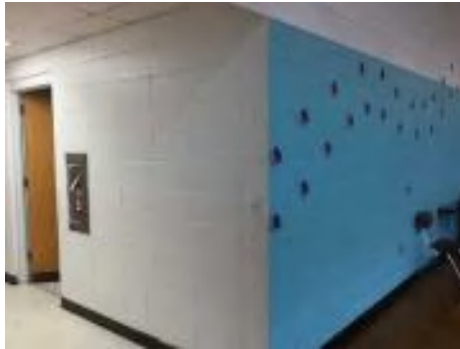
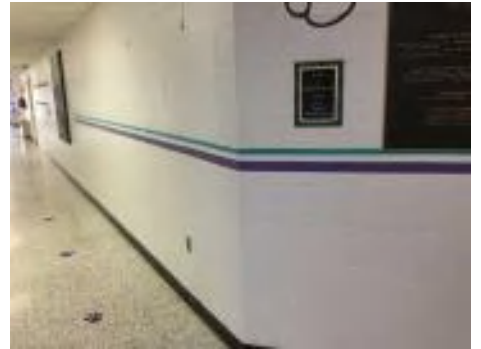
**System:** C1010 - Partitions

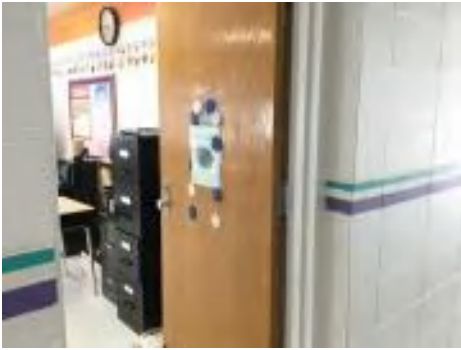
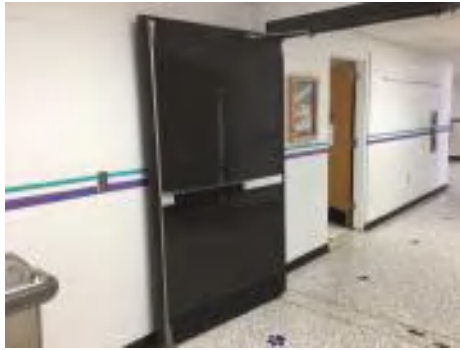
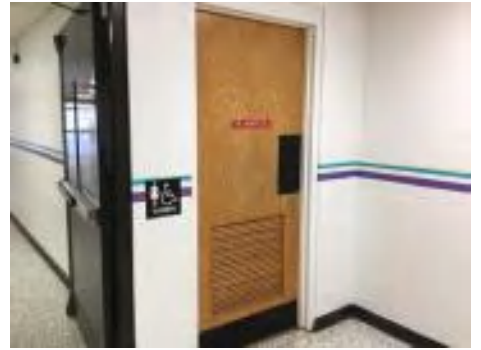
**System:** C1020 - Interior Doors

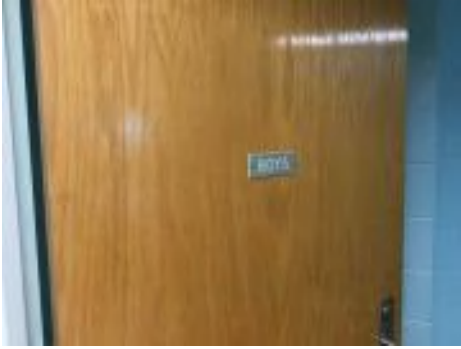
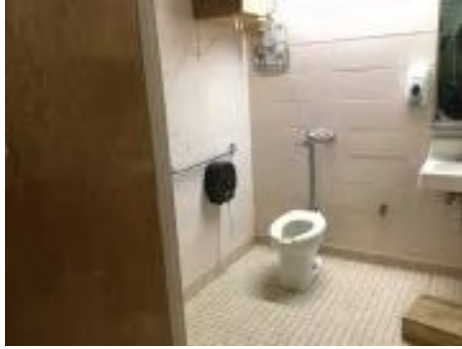
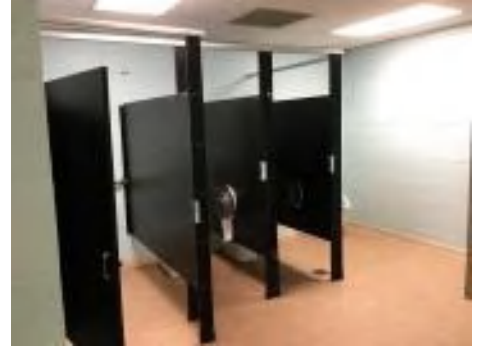
**System:** C1030 - Fittings

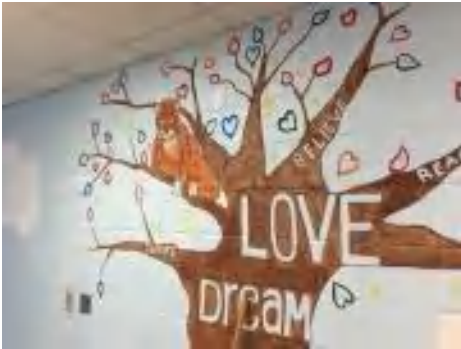
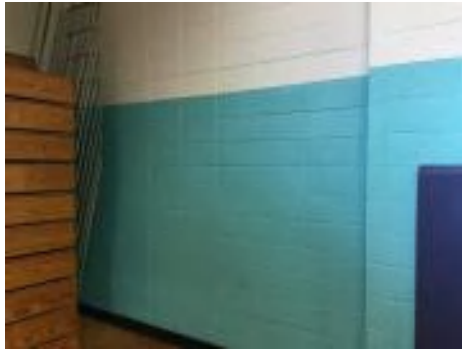
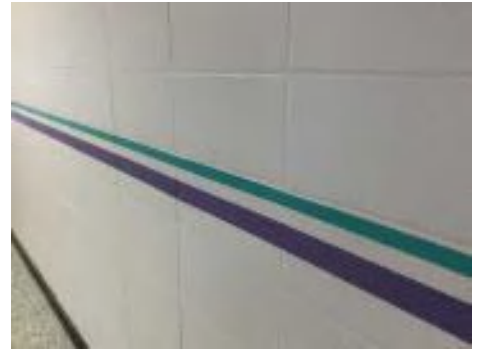
**System:** C3010 - Wall Finishes

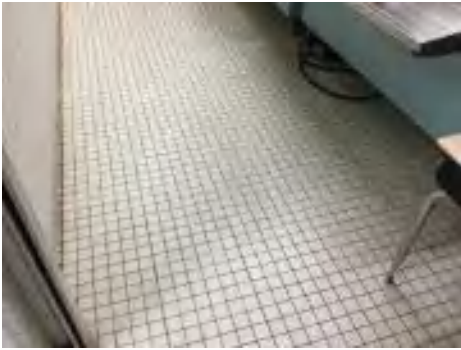
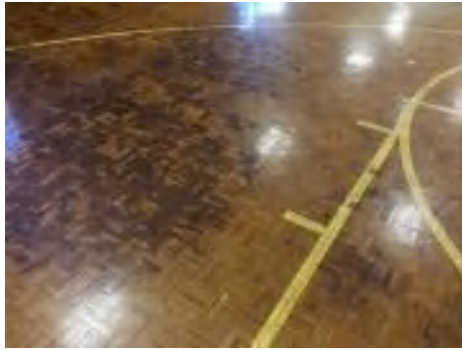
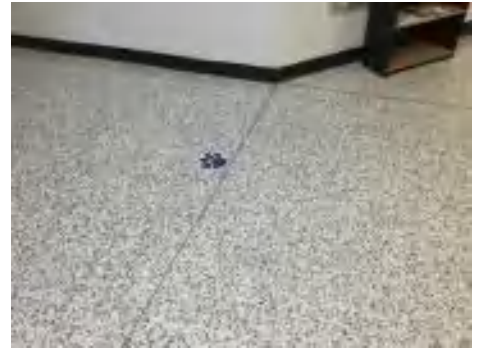
**System:** C3020 - Floor Finishes

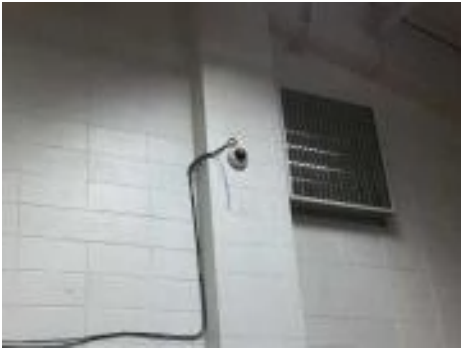
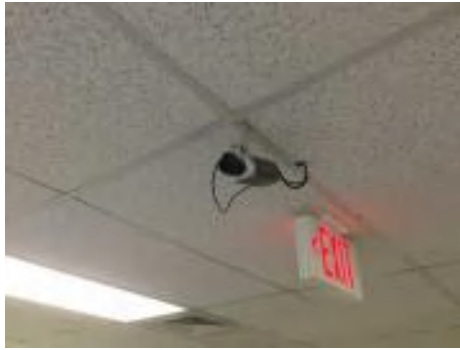
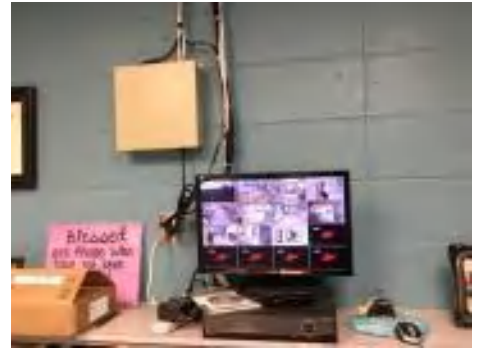
**System:** D5030810 - Security & Detection Systems

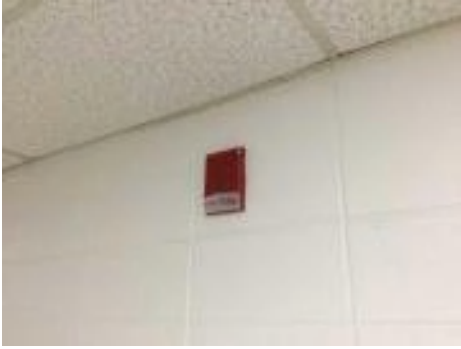
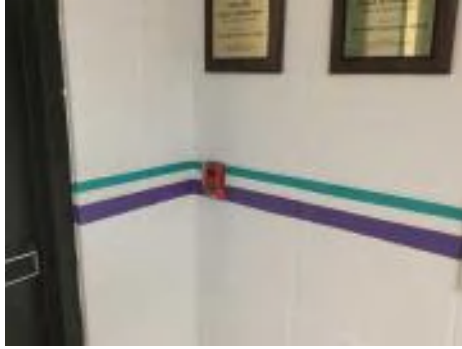
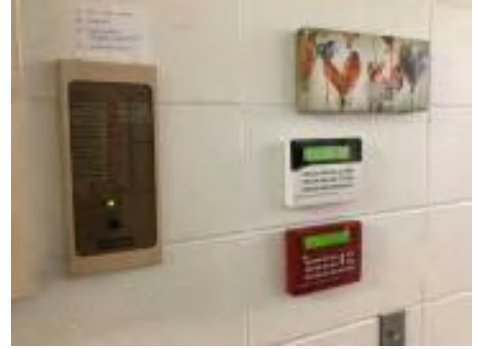
**System:** D5030910 - Fire Alarm Systems

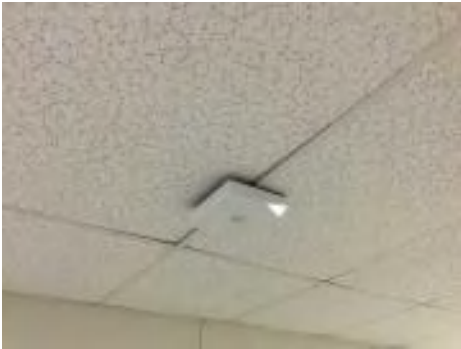
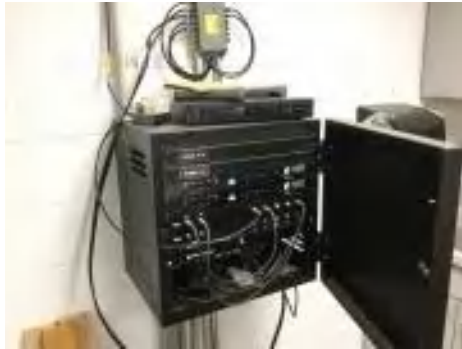
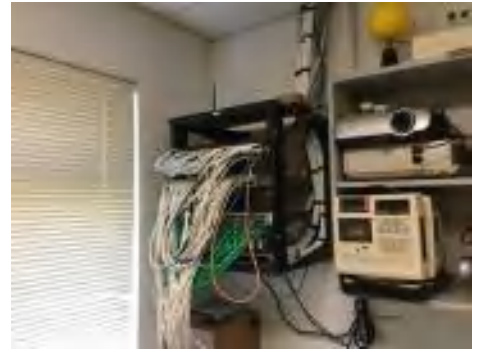
**System:** D5030920 - Data Communication

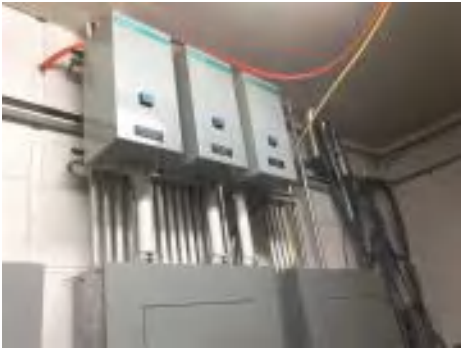
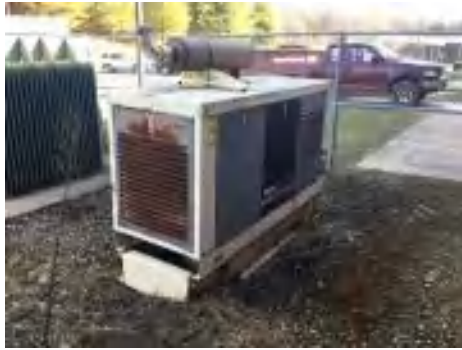
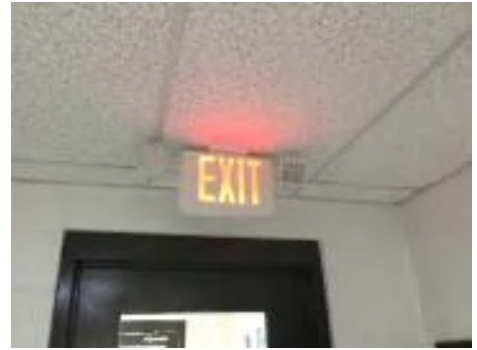
**System:** D5090 - Other Electrical Systems

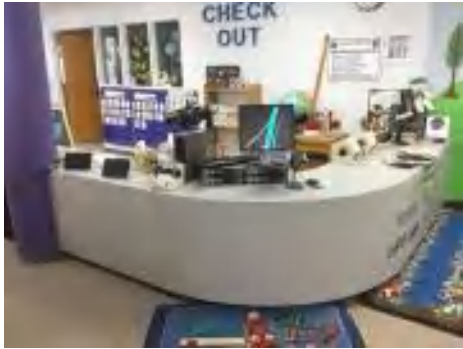
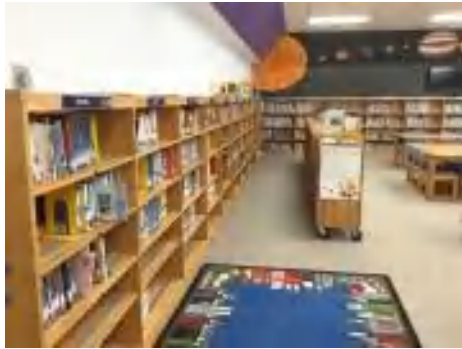
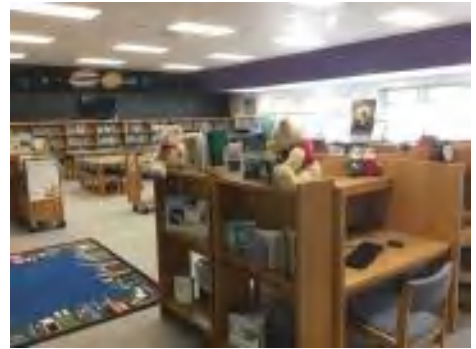
**System:** E1020 - Institutional Equipment

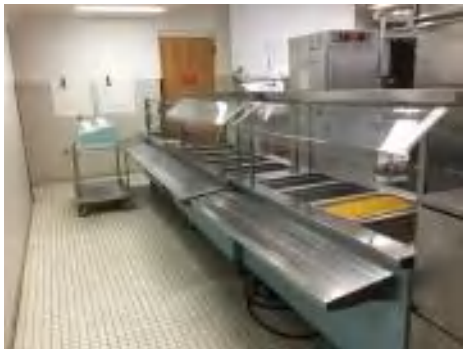
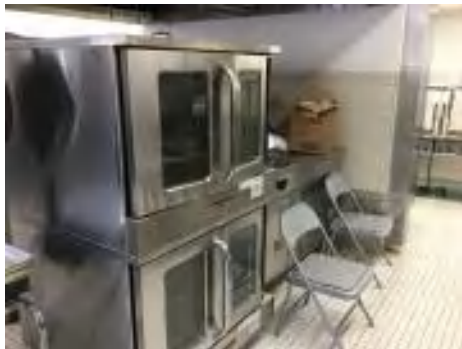
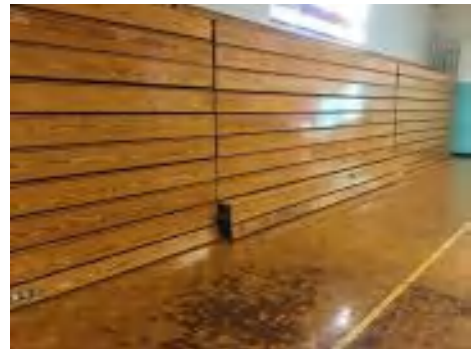
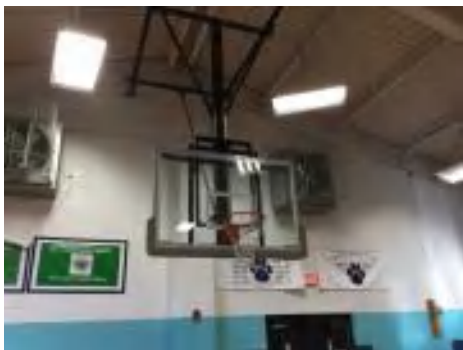
**System:** E1090 - Other Equipment

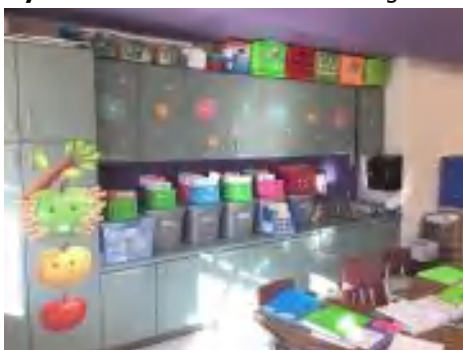
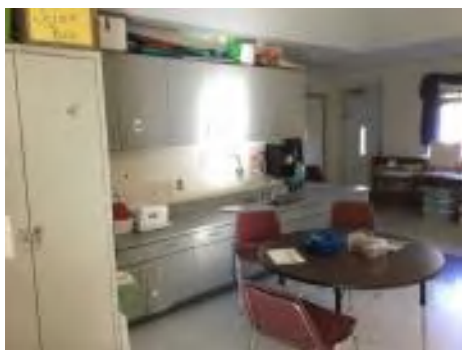
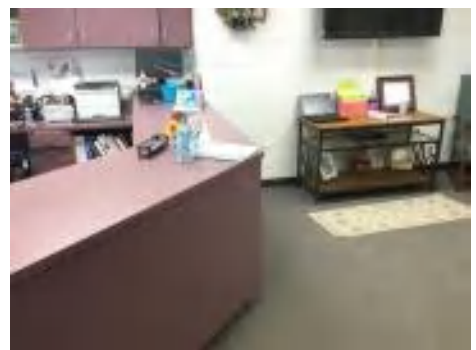
**System:** E2010 - Fixed Furnishings

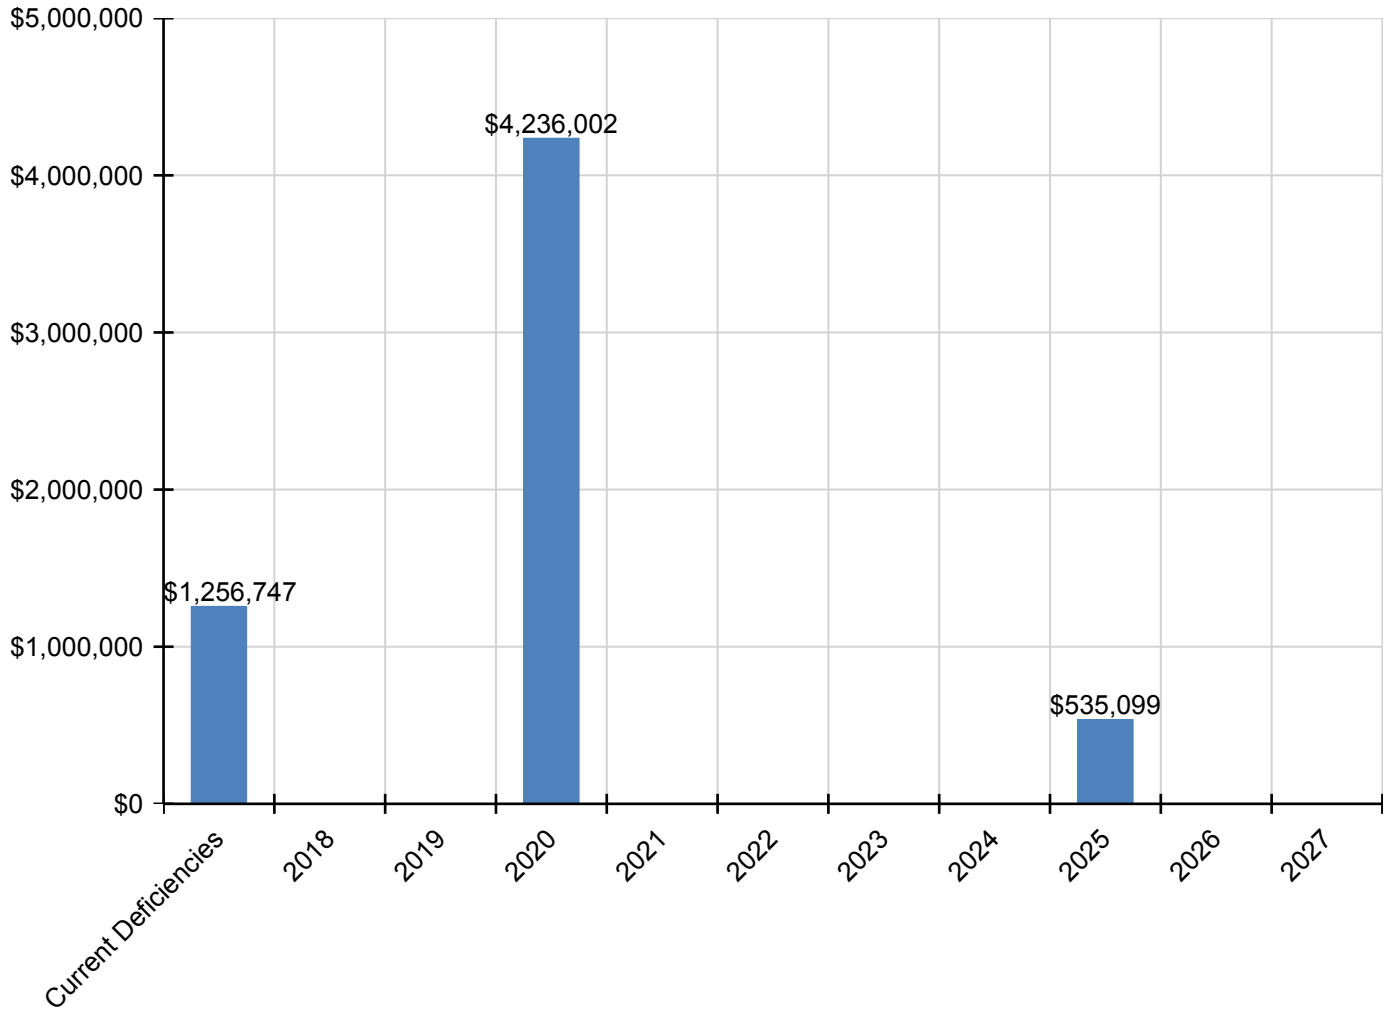
## Forecasted Capital Renewal Requirement

The following chart shows the current building deficiencies and forecasting capital renewal or sustainment requirements over the next ten years.

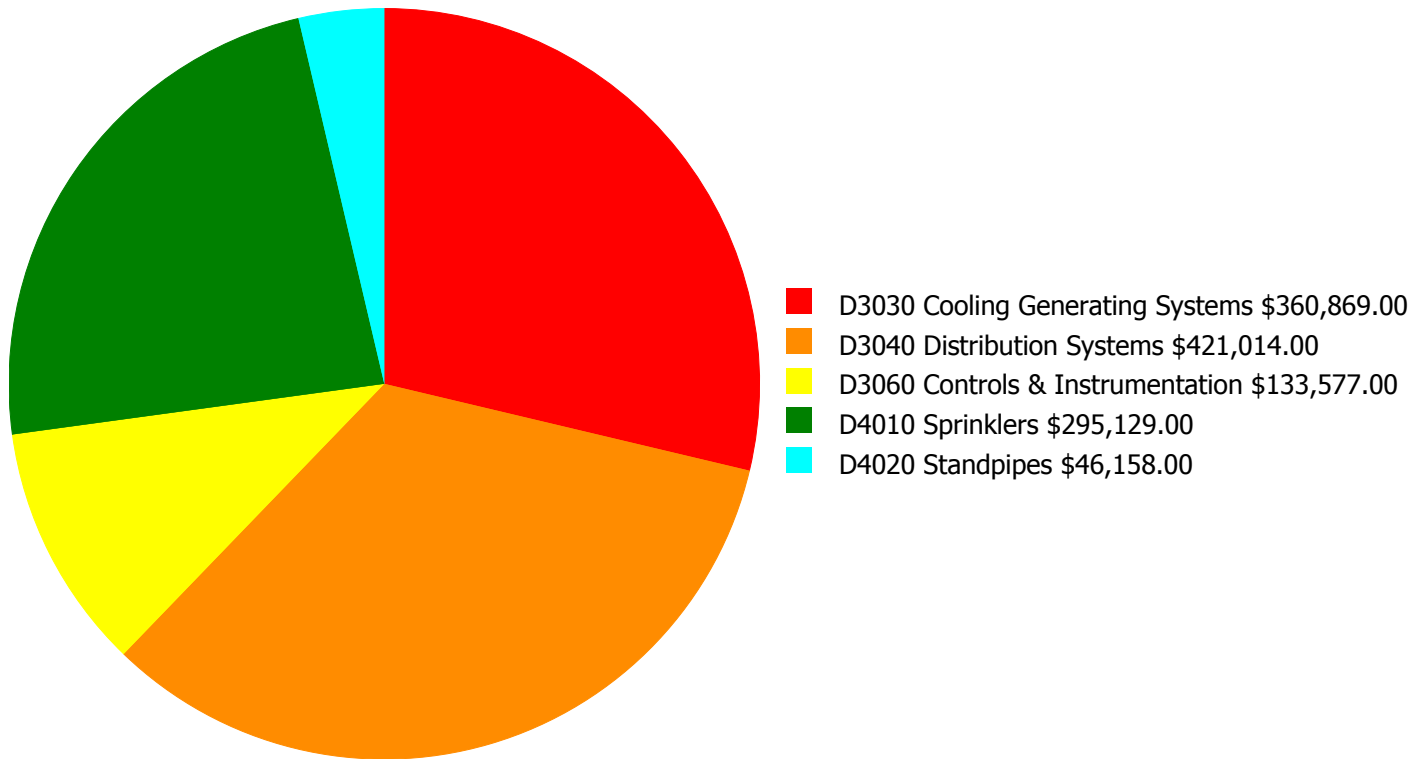
## Deficiency Summary by System

Current deficiencies included assemblies that have reached or exceeded their design life or components of the assemblies that are in need of repair. Assemblies that have reached their design life are identified as current deficiencies and assigned the distress 'Beyond Useful Life'. The following chart lists all current deficiencies associated with this facility.

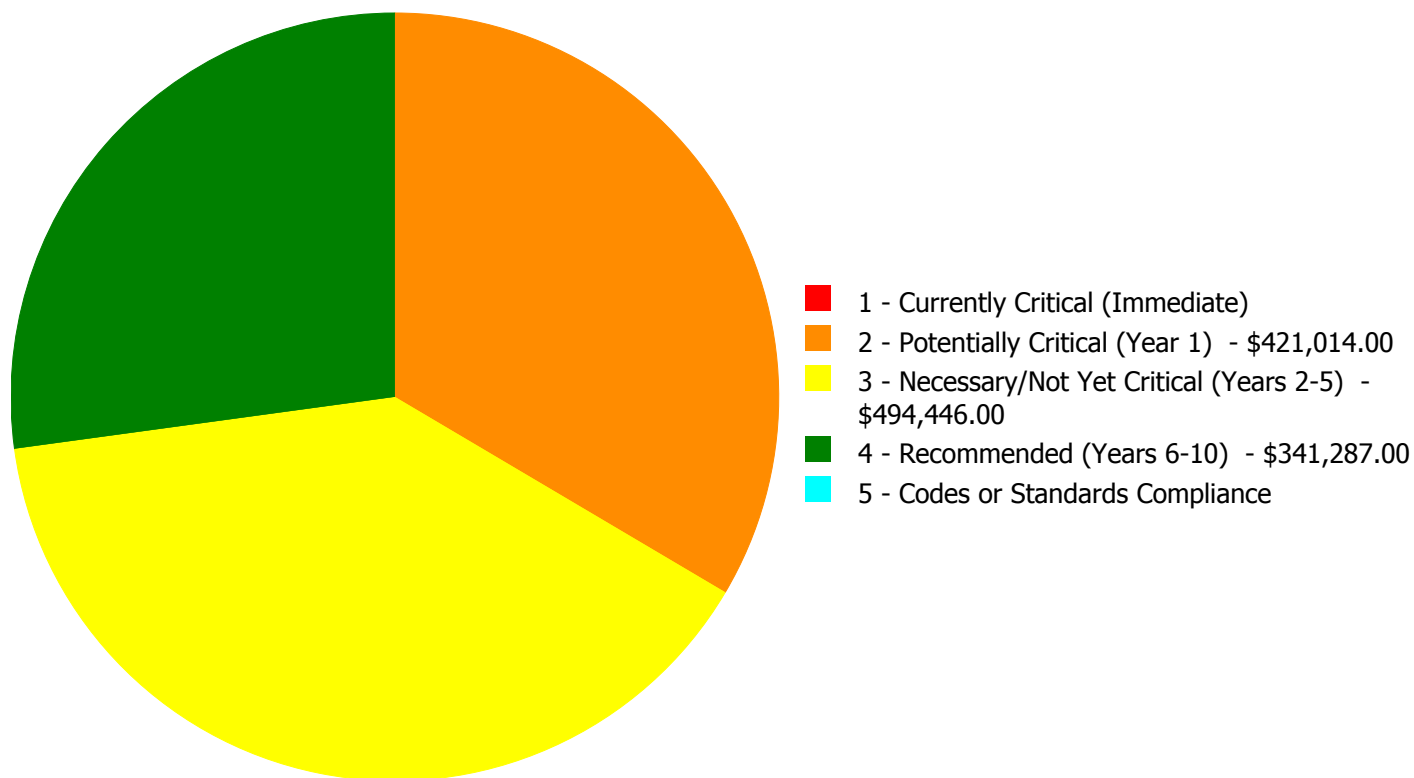
## Deficiency Summary by Priority

The following chart shows the total repair costs broken down by priority. Assessors assigned deficiencies within eCOMET to one of the following priority categories:

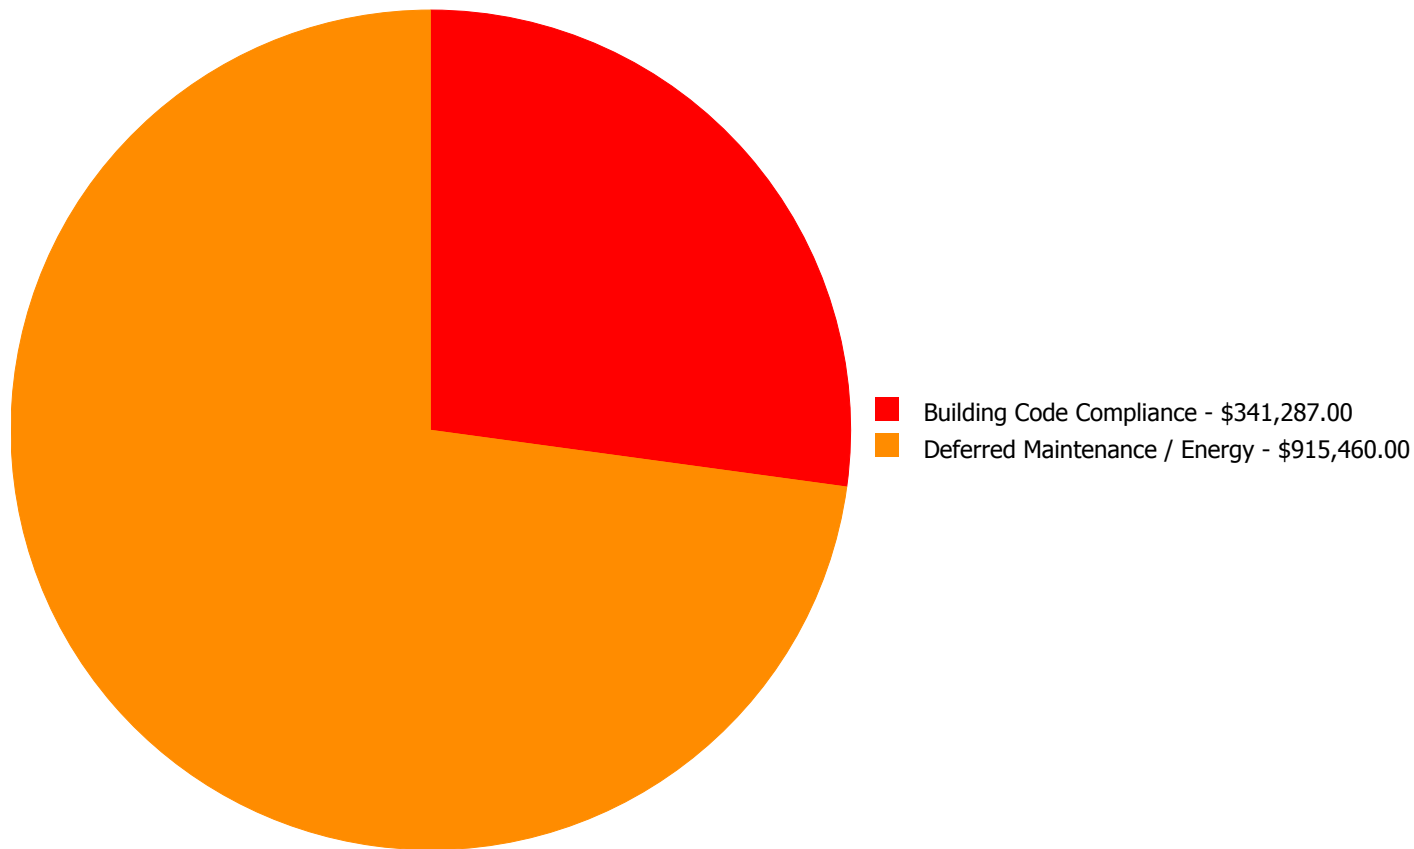
### Deficiency Summary by Category

The following chart shows the total repair costs broken down by deficiency categories. Assessors assigned deficiencies to one of the following categories:

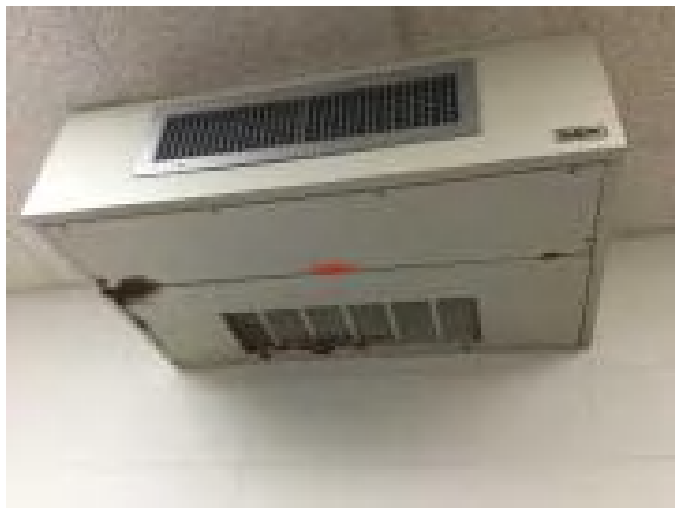
#### **System: D3040 - Distribution Systems**

**Location:** Throughout  
**Distress:** Beyond Service Life  
**Category:** Deferred Maintenance / Energy  
**Priority:** 2 - Potentially Critical (Year 1)  
**Correction:** Renew System  
**Qty:** 63,578.00  
**Unit of Measure:** S.F.  
**Estimate:** \$421,014.00  
**Assessor Name:** Matt Mahaffey  
**Date Created:** 03/01/2017

**Notes:** The air distribution system is aged, becoming logistically unsupportable, and should be replaced.

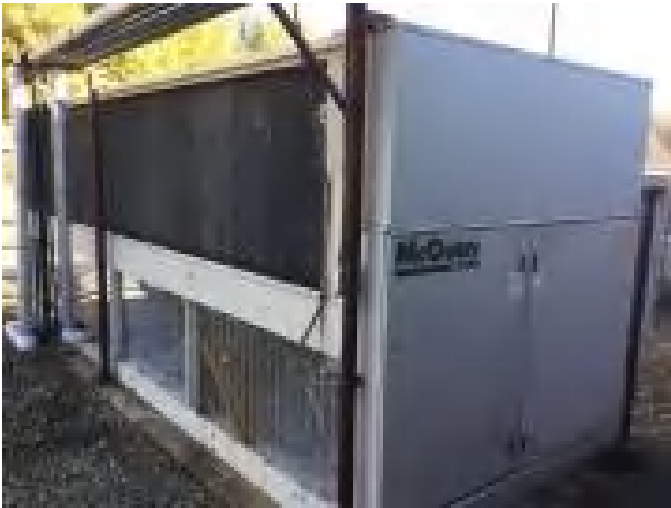
**System: D3030 - Cooling Generating Systems**

**Location:** Exterior  
**Distress:** Beyond Service Life  
**Category:** Deferred Maintenance / Energy  
**Priority:** 3 - Necessary/Not Yet Critical (Years 2-5)  
**Correction:** Renew System  
**Qty:** 63,578.00  
**Unit of Measure:** S.F.  
**Estimate:** \$360,869.00  
**Assessor Name:** Matt Mahaffey  
**Date Created:** 01/27/2017

**Notes:** Chiller is aging and logistically unsupportable, and should be replaced with an energy efficient model.

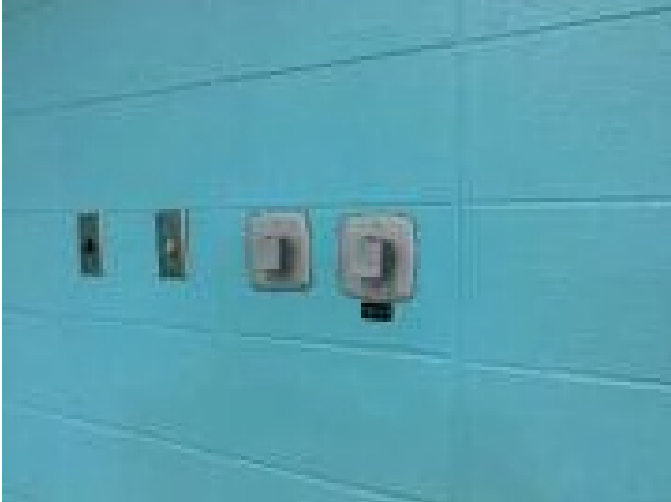
**System: D3060 - Controls & Instrumentation**

**Location:** Throughout  
**Distress:** Beyond Service Life  
**Category:** Deferred Maintenance / Energy  
**Priority:** 3 - Necessary/Not Yet Critical (Years 2-5)  
**Correction:** Renew System  
**Qty:** 63,578.00  
**Unit of Measure:** S.F.  
**Estimate:** \$133,577.00  
**Assessor Name:** Matt Mahaffey  
**Date Created:** 01/27/2017

**Notes:** The HVAC controls are aged, becoming logistically unsupportable, and should be replaced.

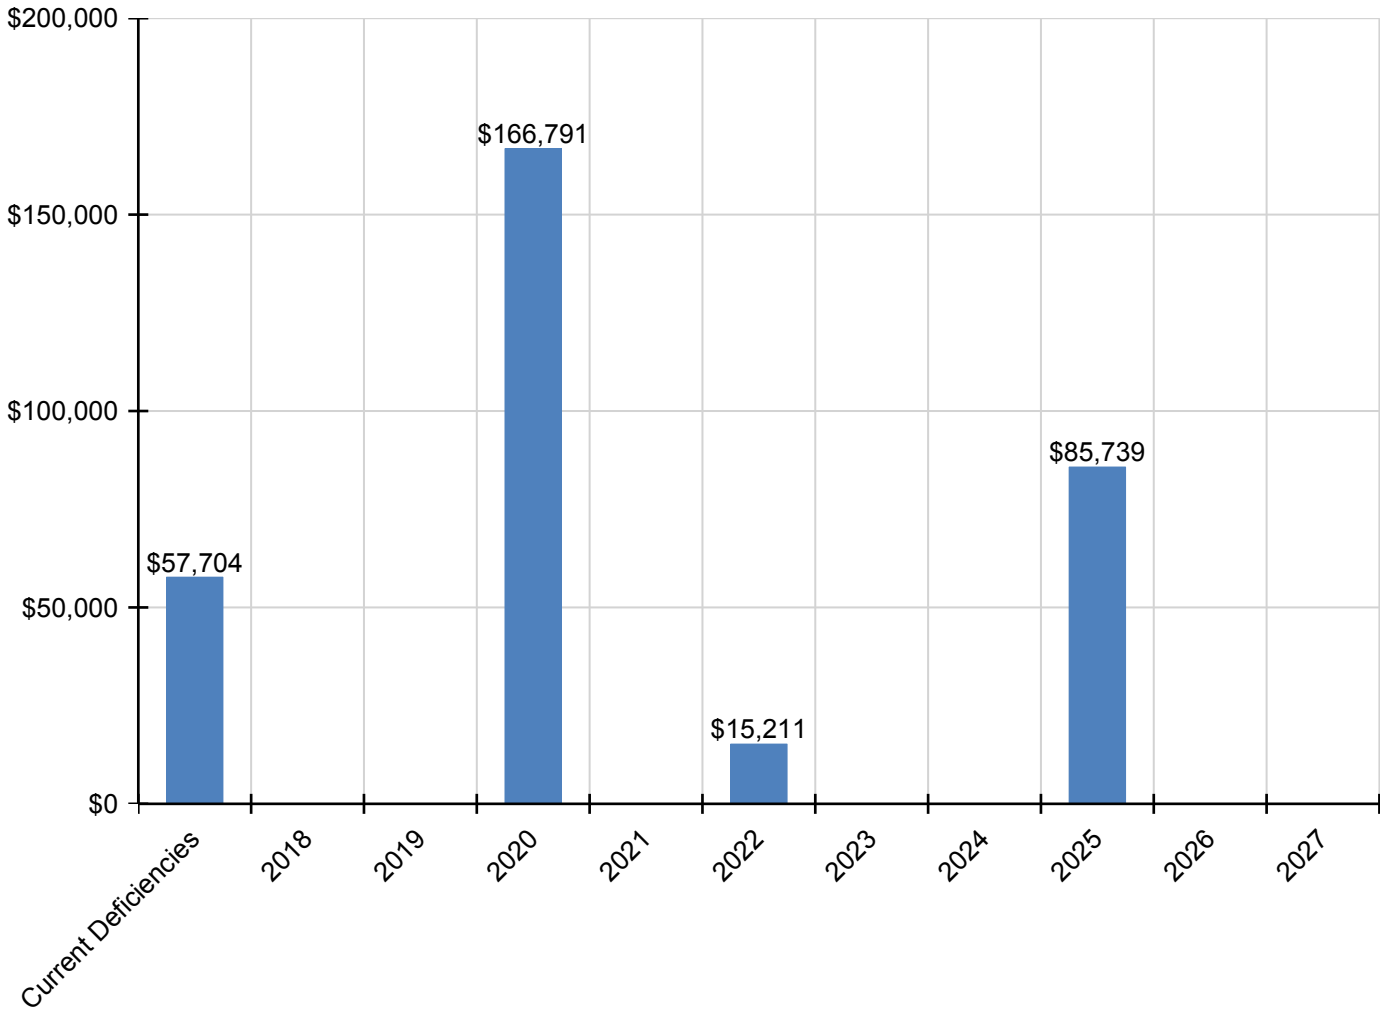
## Forecasted Capital Renewal Requirement

The following chart shows the current building deficiencies and forecasting capital renewal or sustainment requirements over the next ten years.

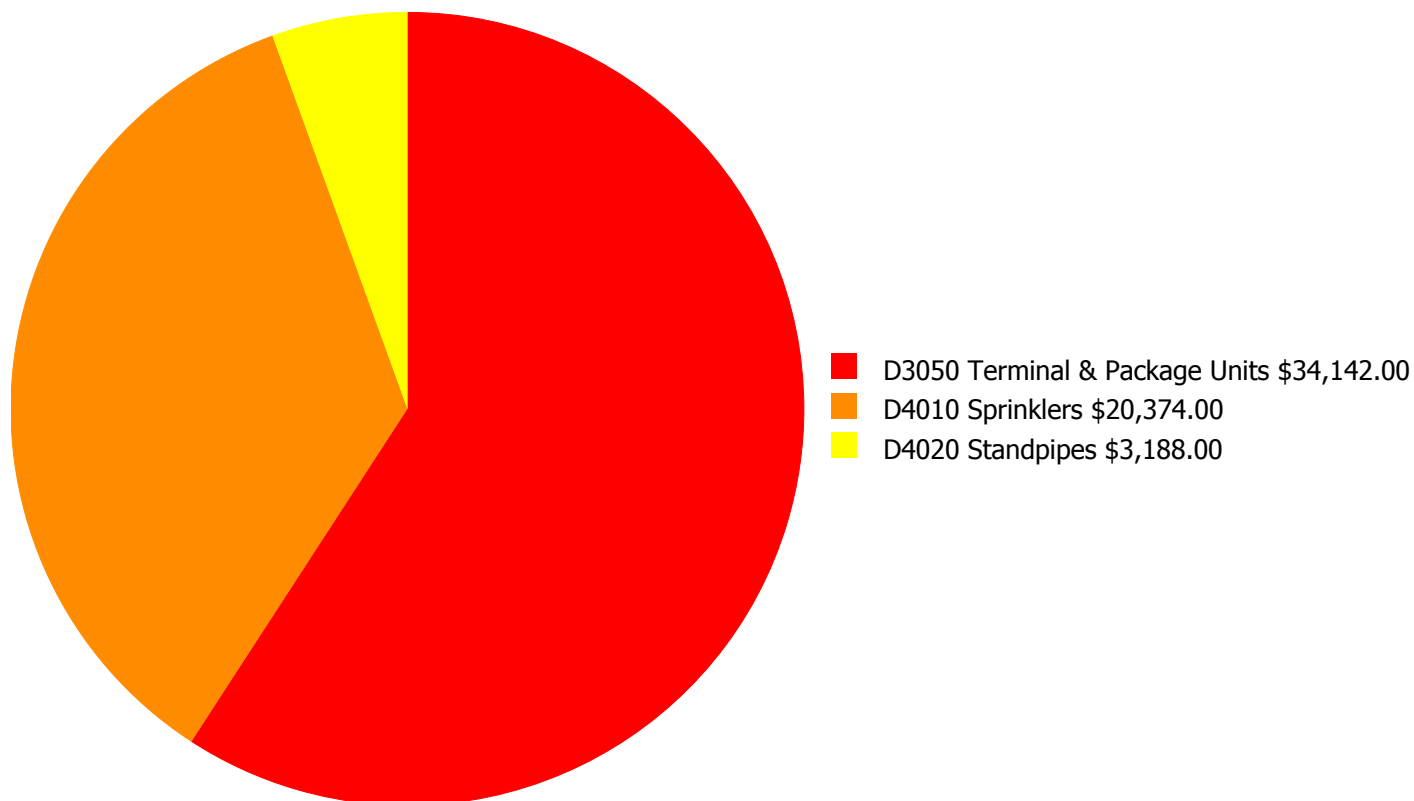
### Deficiency Summary by System

Current deficiencies included assemblies that have reached or exceeded their design life or components of the assemblies that are in need of repair. Assemblies that have reached their design life are identified as current deficiencies and assigned the distress 'Beyond Useful Life'. The following chart lists all current deficiencies associated with this facility.

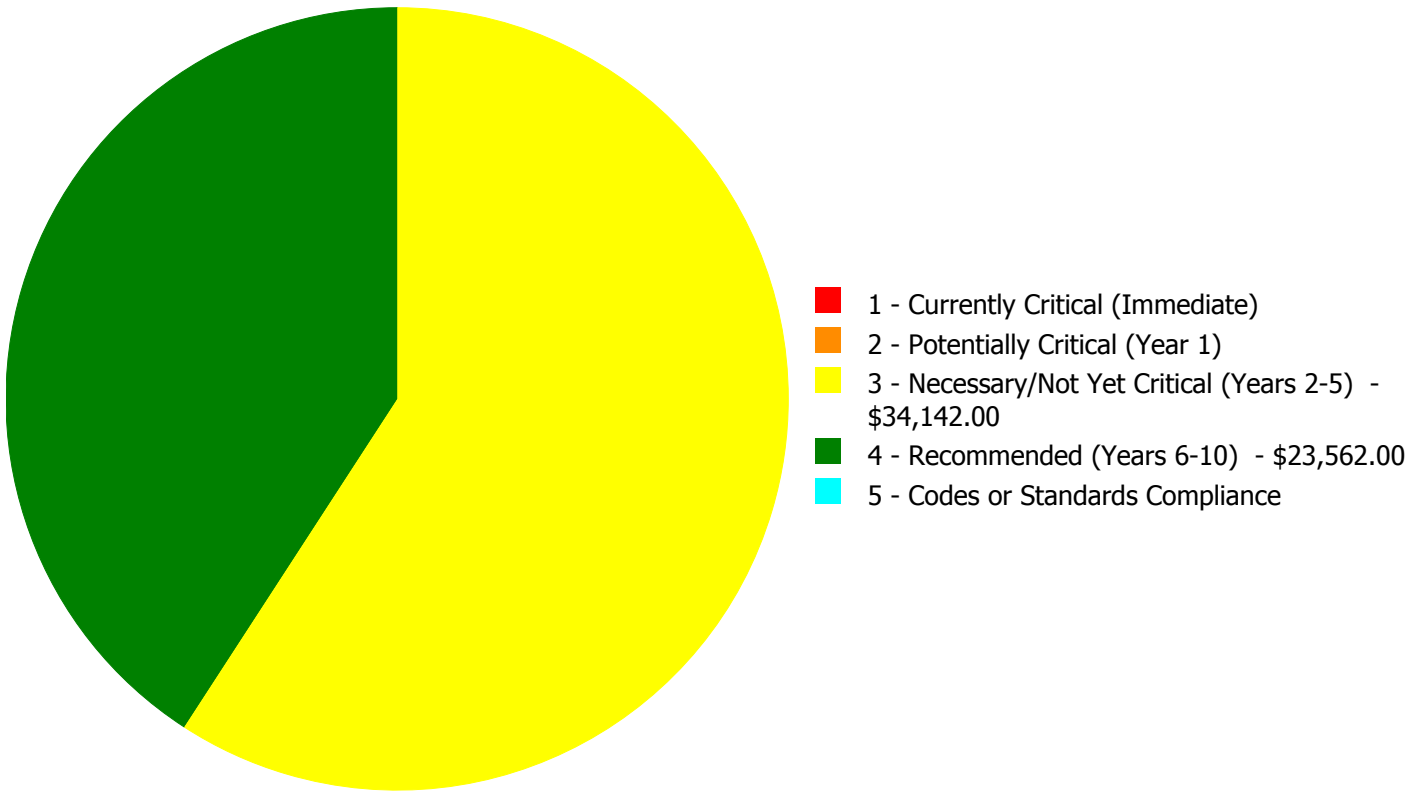
### Deficiency Summary by Priority

The following chart shows the total repair costs broken down by priority. Assessors assigned deficiencies within eCOMET to one of the following priority categories:

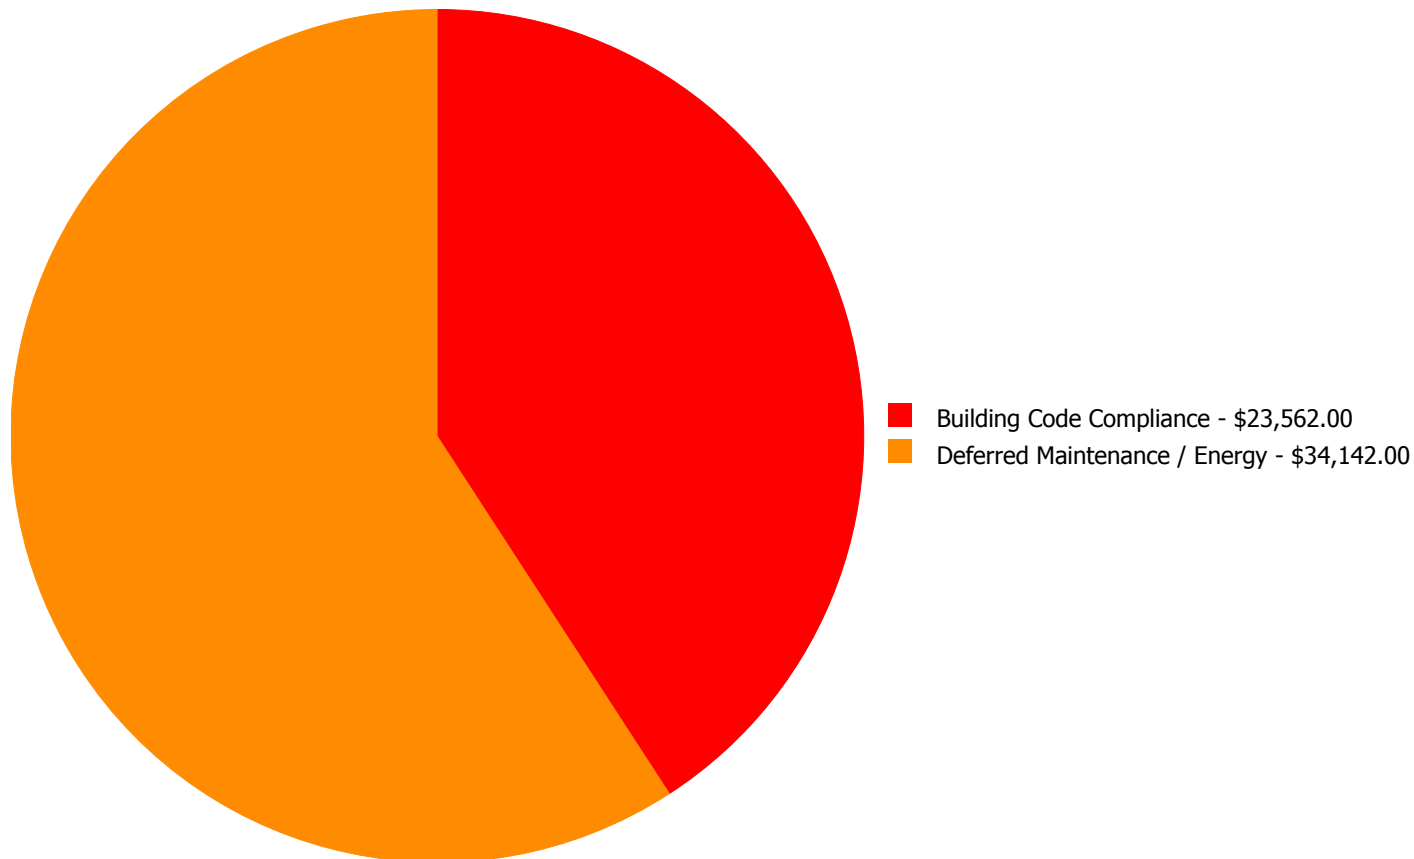
### Deficiency Summary by Category

The following chart shows the total repair costs broken down by deficiency categories. Assessors assigned deficiencies to one of the following categories:

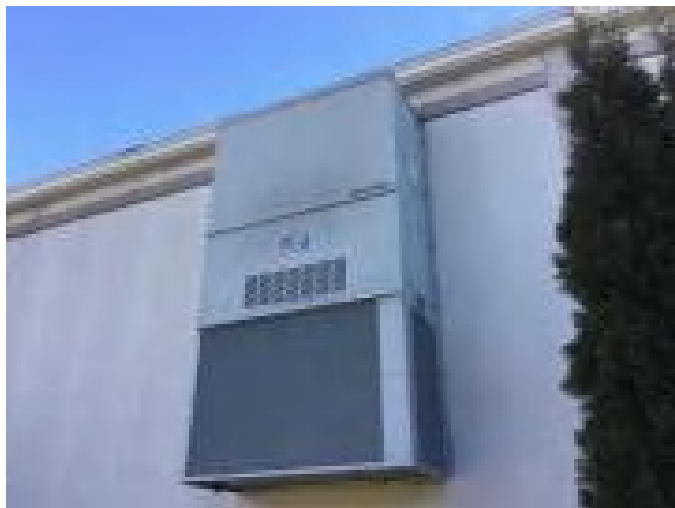
#### System: D3050 - Terminal & Package Units

**Location:** Throughout  
**Distress:** Beyond Service Life  
**Category:** Deferred Maintenance / Energy  
**Priority:** 3 - Necessary/Not Yet Critical (Years 2-5)  
**Correction:** Renew System  
**Qty:** 4,200.00  
**Unit of Measure:** S.F.  
**Estimate:** \$34,142.00  
**Assessor Name:** Terence Davis  
**Date Created:** 01/27/2017

**Notes:** The wall mounted DX condensers are aged, rusted, not energy efficient, and should be replaced.

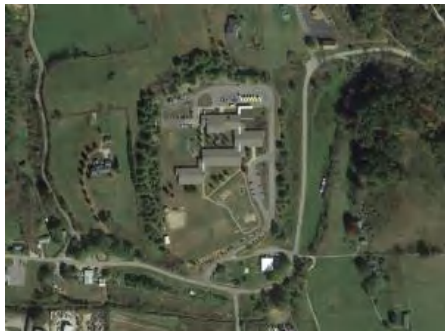
- 1). Aerial Image of Burnsville Elementary School - Feb 24, 2017

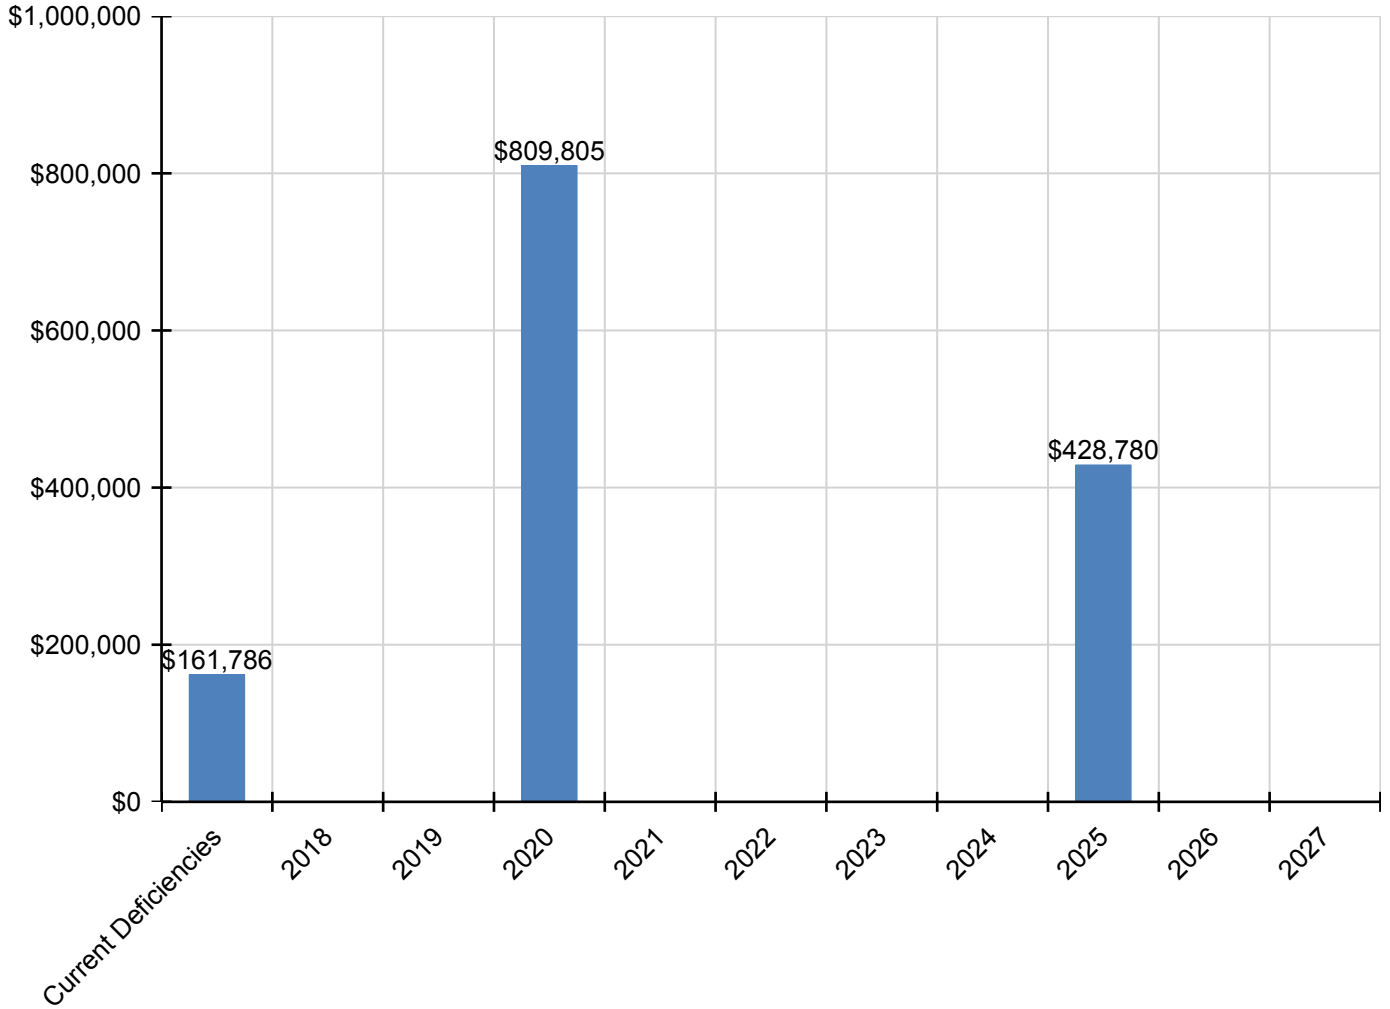
## Forecasted Capital Renewal Requirement

The following chart shows the current building deficiencies and forecasting capital renewal or sustainment requirements over the next ten years.

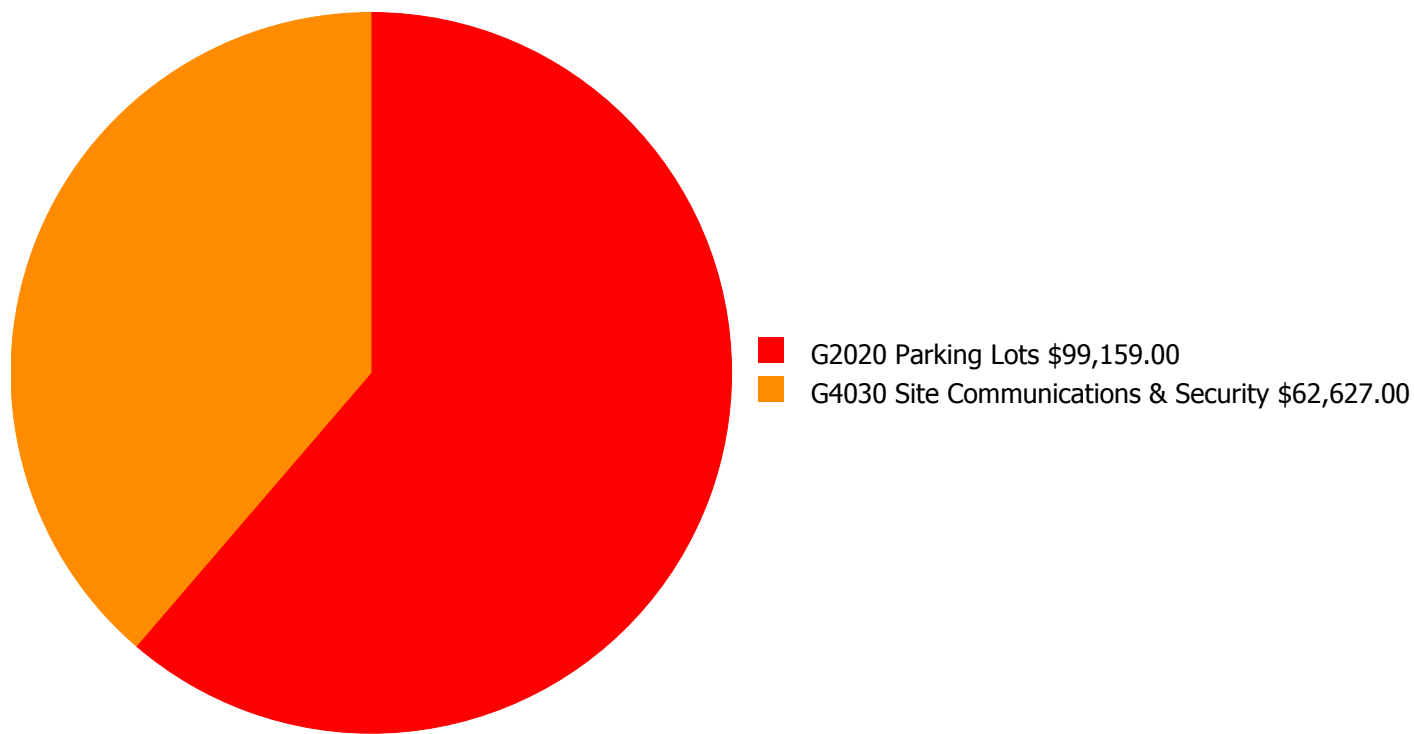
## Deficiency Summary by System

Current deficiencies included assemblies that have reached or exceeded their design life or components of the assemblies that are in need of repair. Assemblies that have reached their design life are identified as current deficiencies and assigned the distress 'Beyond Useful Life'. The following chart lists all current deficiencies associated with this facility.

**Budget Estimate Total: \$161,786.00**
