NC School District/995 Yancey County/High School

# Mountain Heritage High

## Campus Assessment Report

March 7, 2017

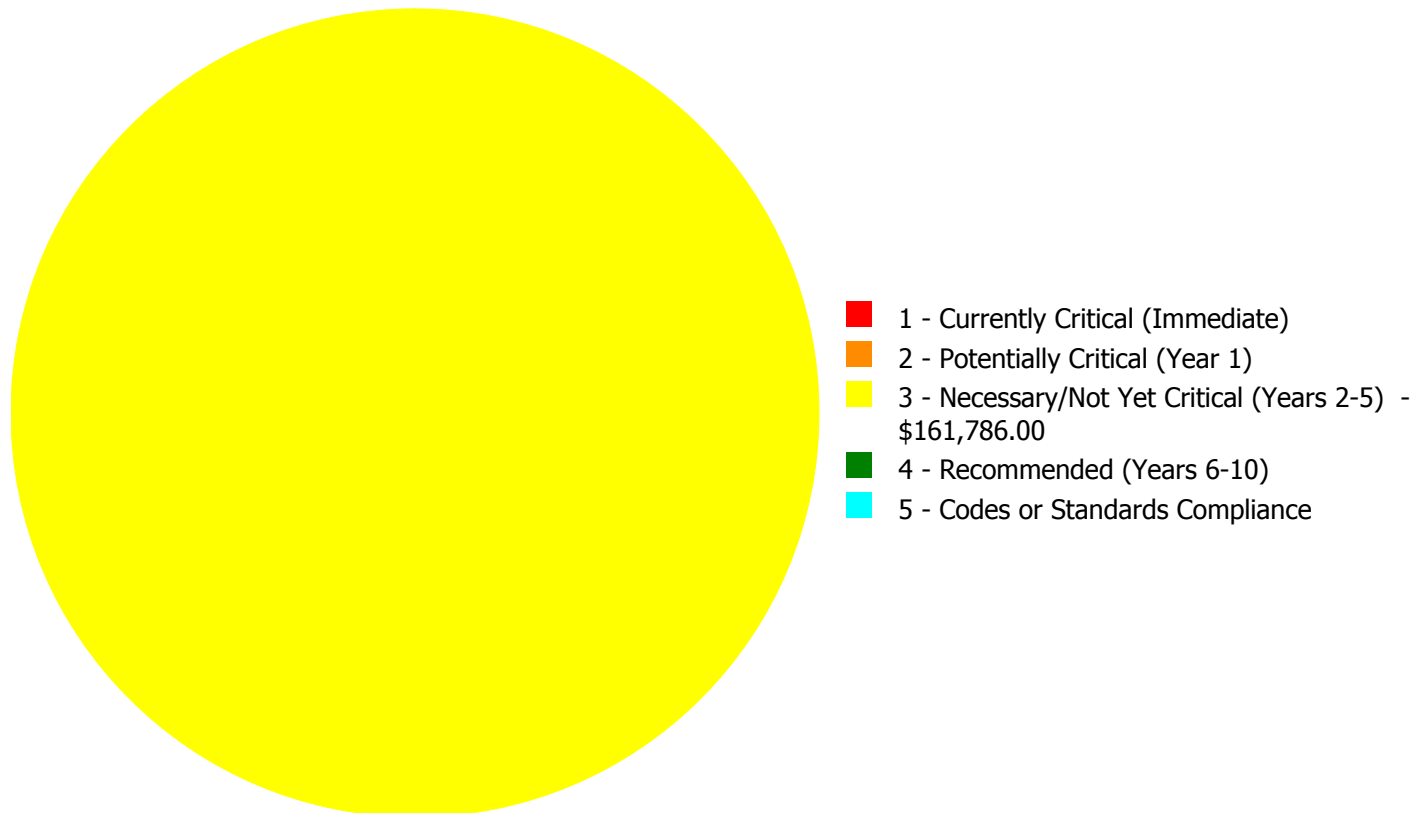
## Deficiency Summary by Priority

The following chart shows the total repair costs broken down by priority. Assessors assigned deficiencies within eCOMET to one of the following priority categories:

**Budget Estimate Total: \$161,786.00**

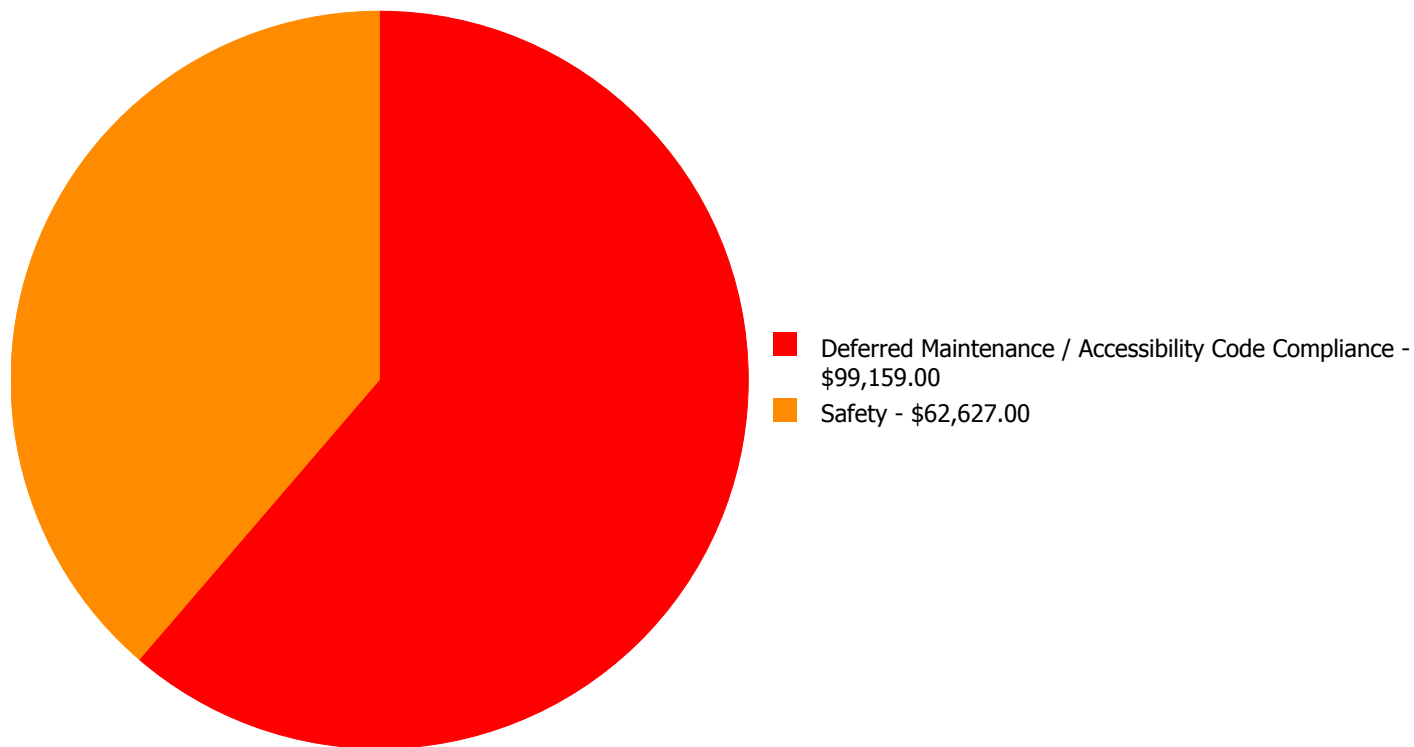
## Deficiency Summary by Category

The following chart shows the total repair costs broken down by deficiency categories. Assessors assigned deficiencies to one of the following categories:

**Budget Estimate Total: \$161,786.00**

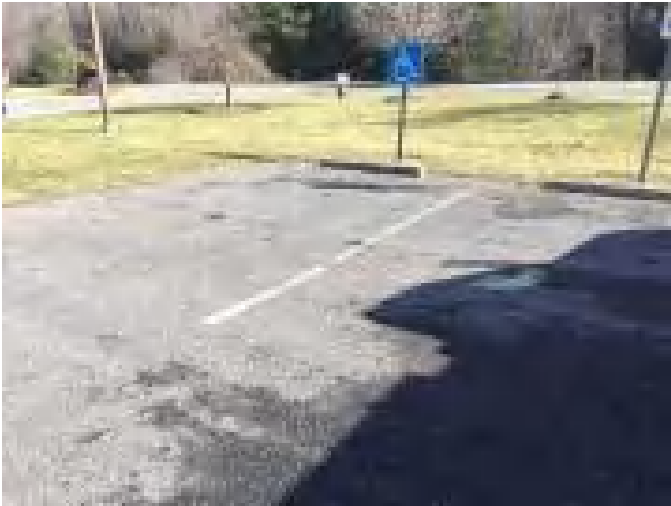
#### System: G2020 - Parking Lots

**Location:** Parking  
**Distress:** Damaged  
**Category:** Deferred Maintenance / Accessibility Code Compliance  
**Priority:** 3 - Necessary/Not Yet Critical (Years 2-5)  
**Correction:** Renew System  
**Qty:** 67,778.00  
**Unit of Measure:** S.F.  
**Estimate:** \$99,159.00  
**Assessor Name:** Matt Mahaffey  
**Date Created:** 01/27/2017

**Notes:** The parking lot is aged, has many repairs and potholes, and should be replaced and re-striped. ADA signs height needs to be adjusted per minimum ADA standards.

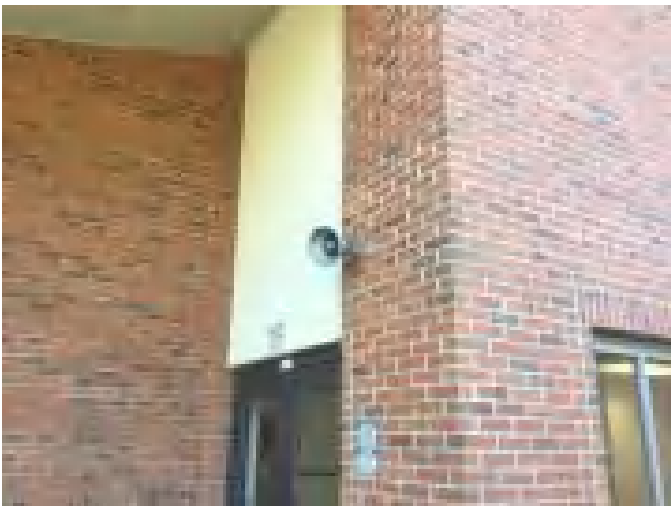
#### System: G4030 - Site Communications & Security

**Location:** Site  
**Distress:** Inadequate  
**Category:** Safety  
**Priority:** 3 - Necessary/Not Yet Critical (Years 2-5)  
**Correction:** Renew System  
**Qty:** 67,778.00  
**Unit of Measure:** S.F.  
**Estimate:** \$62,627.00  
**Assessor Name:** Matt Mahaffey  
**Date Created:** 01/27/2017

**Notes:** Site security is inadequate and requires more cameras for coverage.

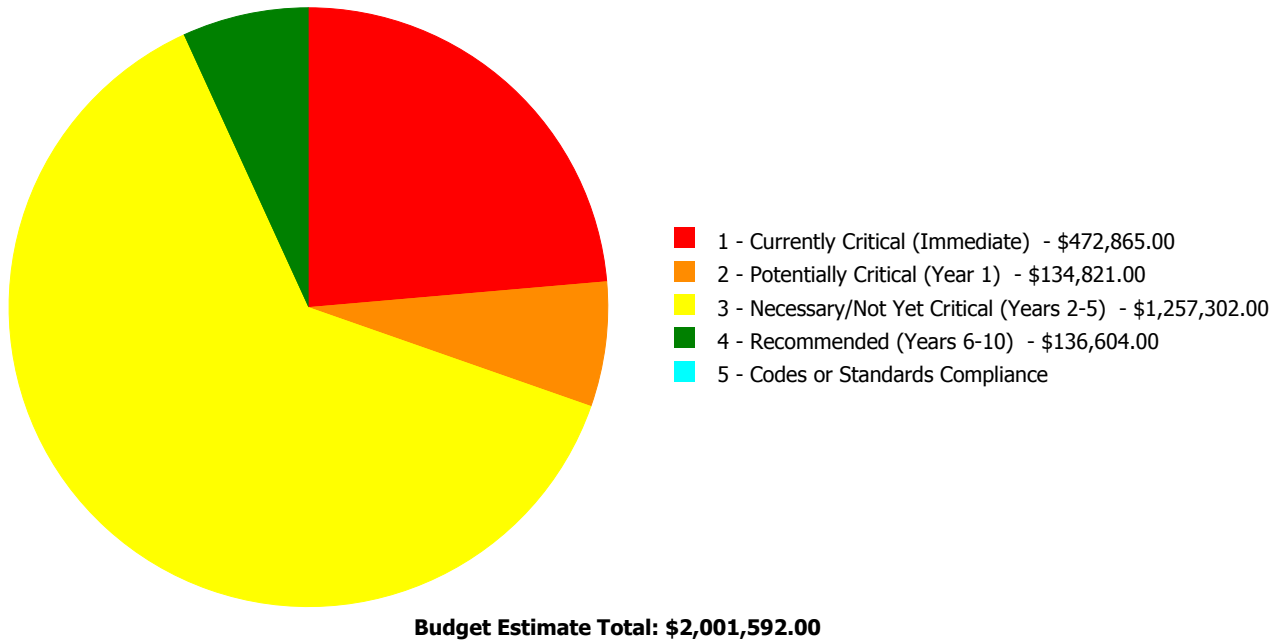
**Deficiencies By Priority**

Facility Name	Gross Area (S.F.)	FCI %	1 - Currently Critical (Immediate)	2 - Potentially Critical (Year 1)	3 - Necessary/Not Yet Critical (Years 2-5)	4 - Recommended (Years 6-10)	5 - Codes or Standards Compliance
1936 Main	22,350	35.46	\$433,925.00	\$73,017.00	\$814,103.00	\$125,384.00	\$0.00
1961 Classrooms	2,000	43.07	\$0.00	\$25,476.00	\$91,058.00	\$11,220.00	\$0.00
1961 Pump House	64	33.51	\$0.00	\$610.00	\$2,752.00	\$0.00	\$0.00
Site	24,414	62.75	\$38,940.00	\$35,718.00	\$349,389.00	\$0.00	\$0.00
<b>Total:</b>		<b>39.54</b>	<b>\$472,865.00</b>	<b>\$134,821.00</b>	<b>\$1,257,302.00</b>	<b>\$136,604.00</b>	<b>\$0.00</b>

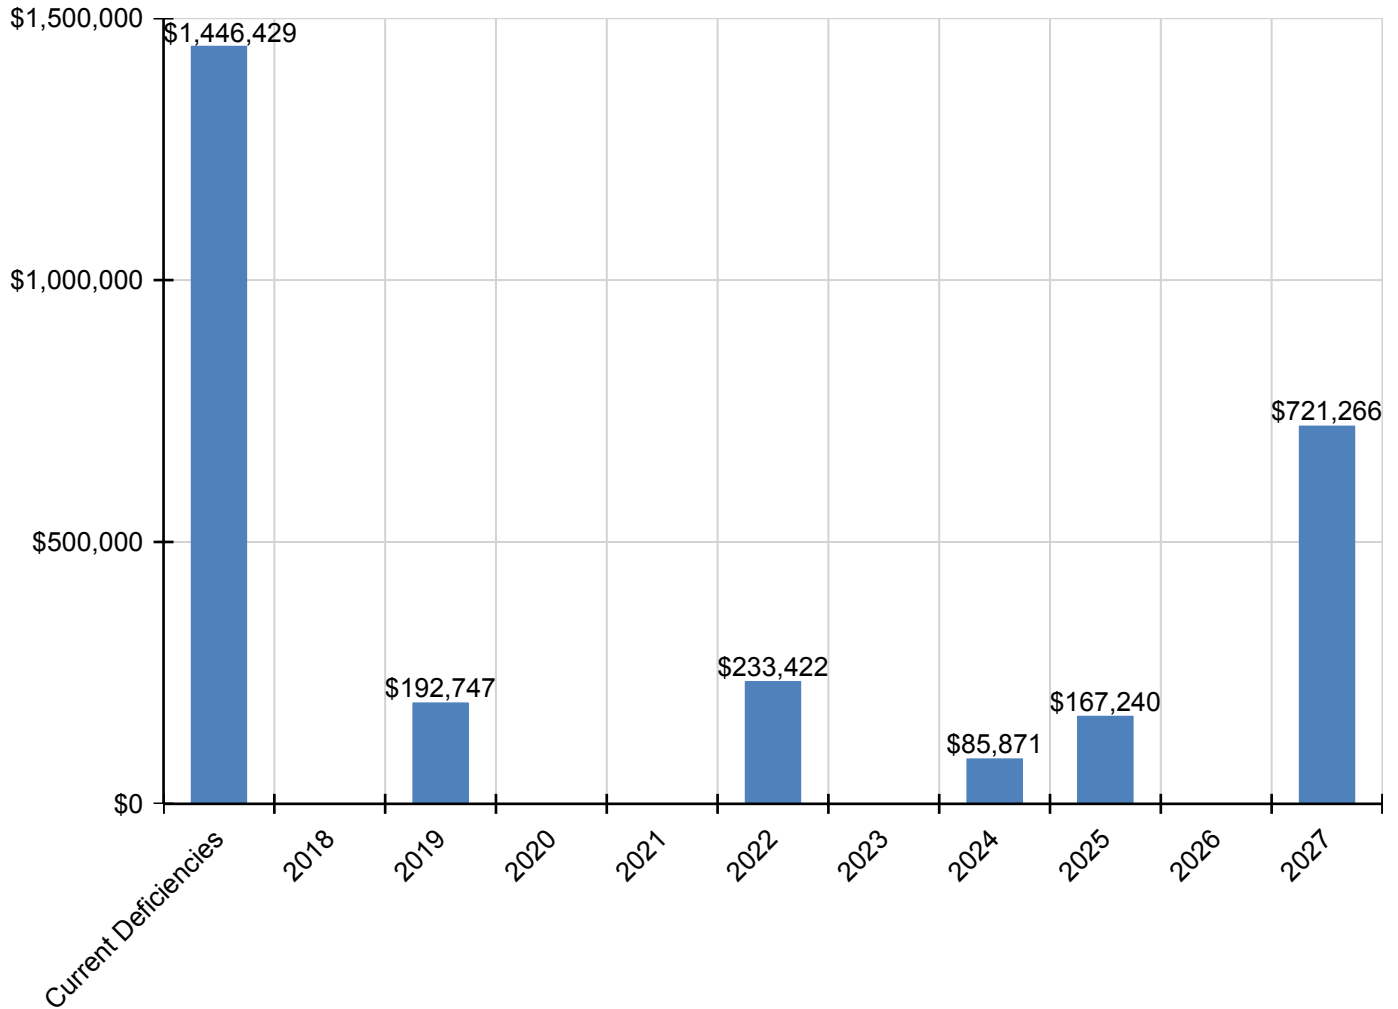
## Forecasted Capital Renewal Requirement

The following chart shows the current building deficiencies and forecasting capital renewal or sustainment requirements over the next ten years.

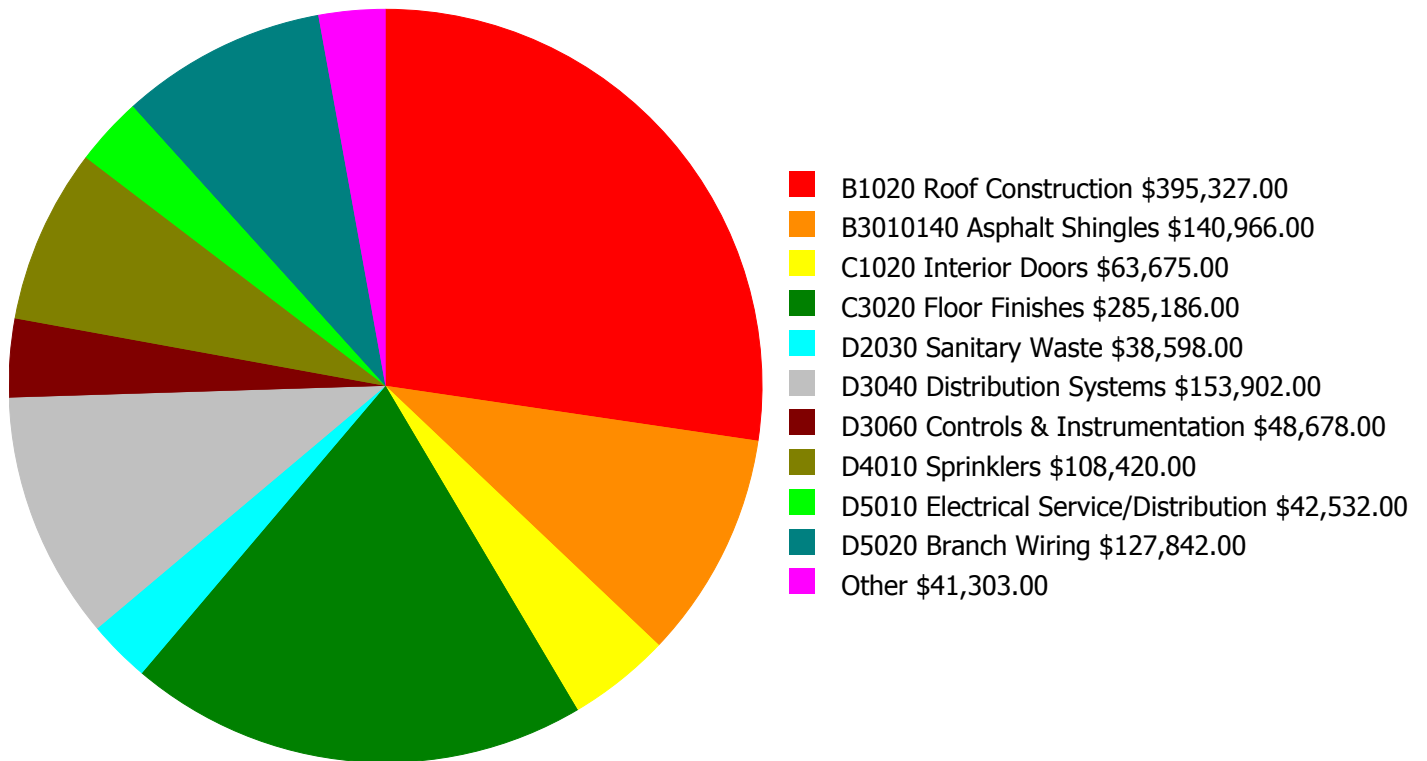
### Deficiency Summary by System

Current deficiencies included assemblies that have reached or exceeded their design life or components of the assemblies that are in need of repair. Assemblies that have reached their design life are identified as current deficiencies and assigned the distress 'Beyond Useful Life'. The following chart lists all current deficiencies associated with this facility.

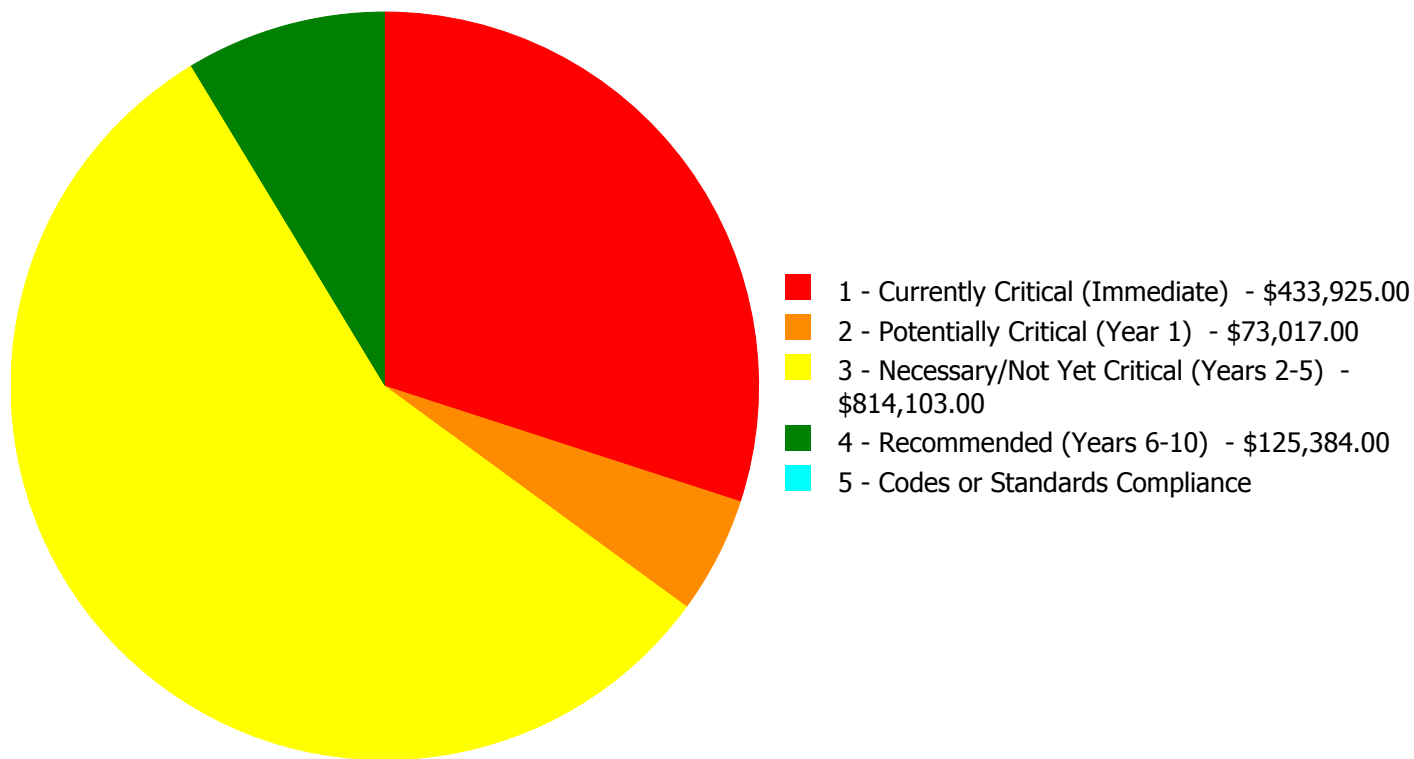
### Deficiency Summary by Priority

The following chart shows the total repair costs broken down by priority. Assessors assigned deficiencies within eCOMET to one of the following priority categories:

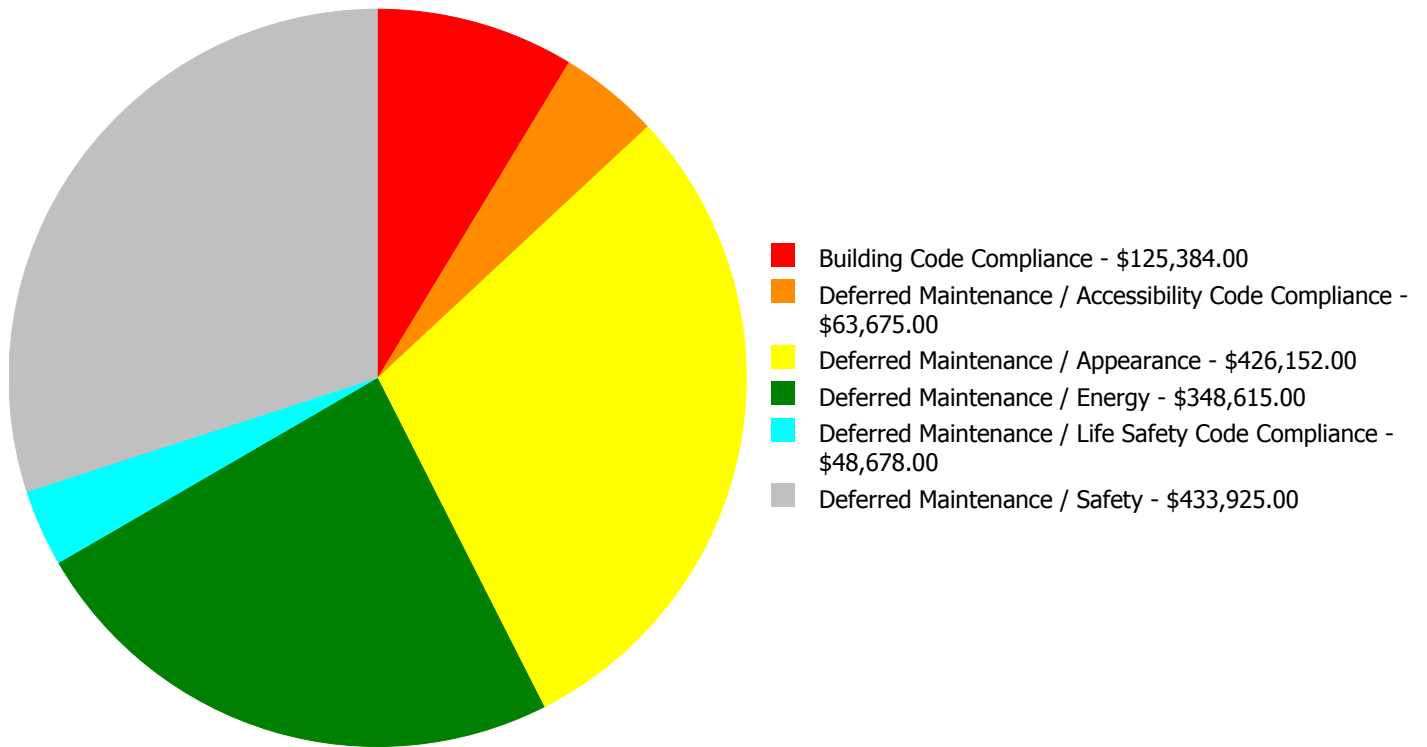
## Deficiency Summary by Category

The following chart shows the total repair costs broken down by deficiency categories. Assessors assigned deficiencies to one of the following categories:

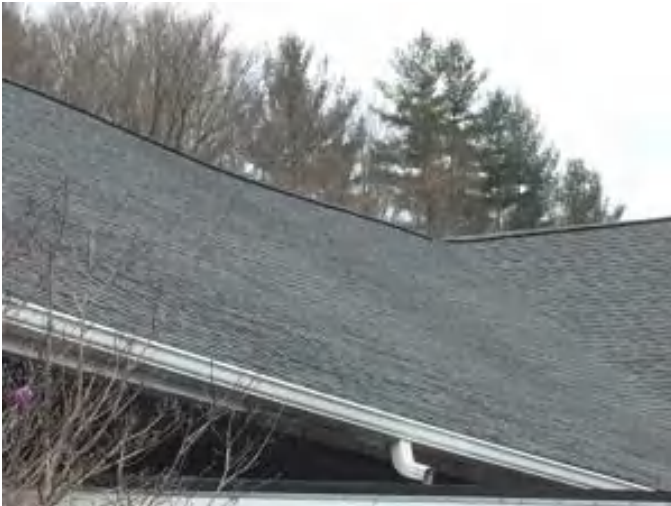
#### System: B1020 - Roof Construction

**Location:** Main roof  
**Distress:** Failing  
**Category:** Deferred Maintenance / Safety  
**Priority:** 1 - Currently Critical (Immediate)  
**Correction:** Renew System  
**Qty:** 22,350.00  
**Unit of Measure:** S.F.  
**Estimate:** \$395,327.00  
**Assessor Name:** Terence Davis  
**Date Created:** 02/10/2017

**Notes:** The original wood roof construction is failing and should be replaced. It was recommended that no person should get on the roof for fear of falling through. Roofing structure failure is also causing roof deck failure.

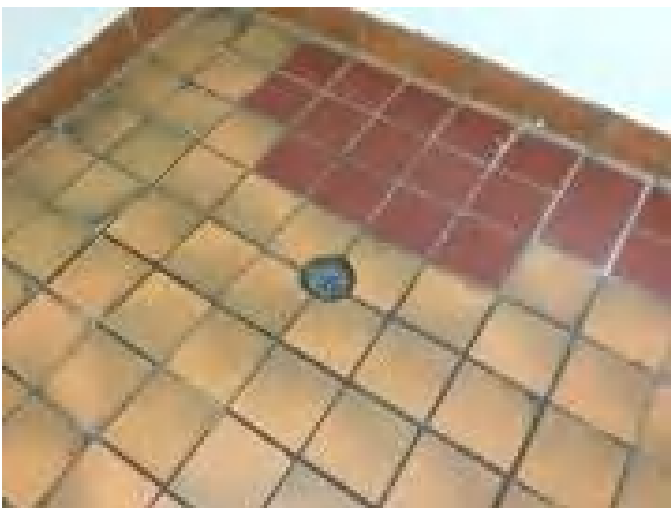
#### System: D2030 - Sanitary Waste

**Location:** Throughout  
**Distress:** Failing  
**Category:** Deferred Maintenance / Safety  
**Priority:** 1 - Currently Critical (Immediate)  
**Correction:** Renew System  
**Qty:** 22,350.00  
**Unit of Measure:** S.F.  
**Estimate:** \$38,598.00  
**Assessor Name:** Terence Davis  
**Date Created:** 01/27/2017

**Notes:** The sanitary waste system is aged, has reported periodic failures, and should be replaced. System requires daily pump-out.

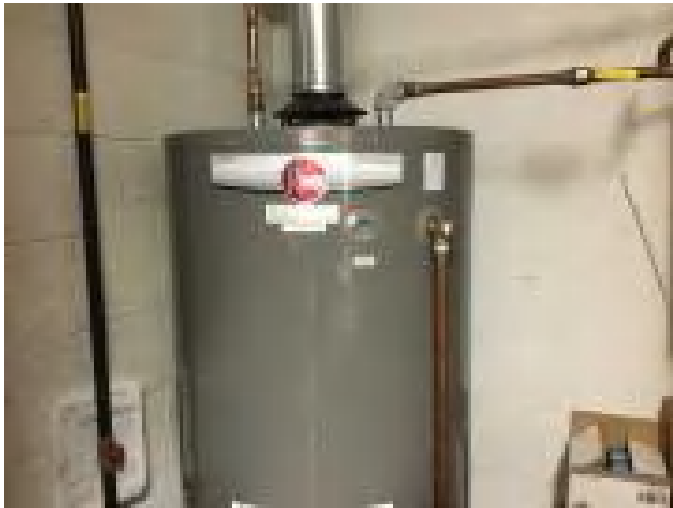
**System: D2020 - Domestic Water Distribution**

**Location:** Throughout  
**Distress:** Beyond Service Life  
**Category:** Deferred Maintenance / Energy  
**Priority:** 2 - Potentially Critical (Year 1)  
**Correction:** Renew System  
**Qty:** 22,350.00  
**Unit of Measure:** S.F.  
**Estimate:** \$24,339.00  
**Assessor Name:** Terence Davis  
**Date Created:** 01/27/2017

**Notes:** The domestic water distribution system is aged and should be replaced.

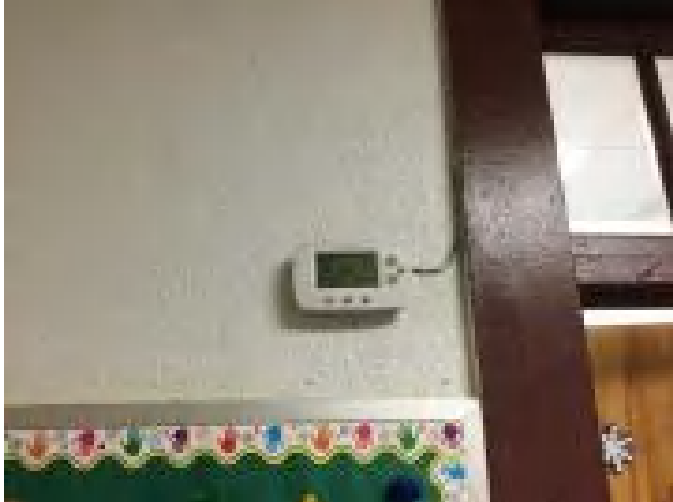
**System: D3060 - Controls & Instrumentation**

**Location:** Throughout  
**Distress:** Inadequate  
**Category:** Deferred Maintenance / Life Safety Code Compliance  
**Priority:** 2 - Potentially Critical (Year 1)  
**Correction:** Renew System  
**Qty:** 22,350.00  
**Unit of Measure:** S.F.  
**Estimate:** \$48,678.00  
**Assessor Name:** Terence Davis  
**Date Created:** 01/27/2017

**Notes:** HVAC controls are limited to one thermostat near the front door and is unreliable and should be replaced.

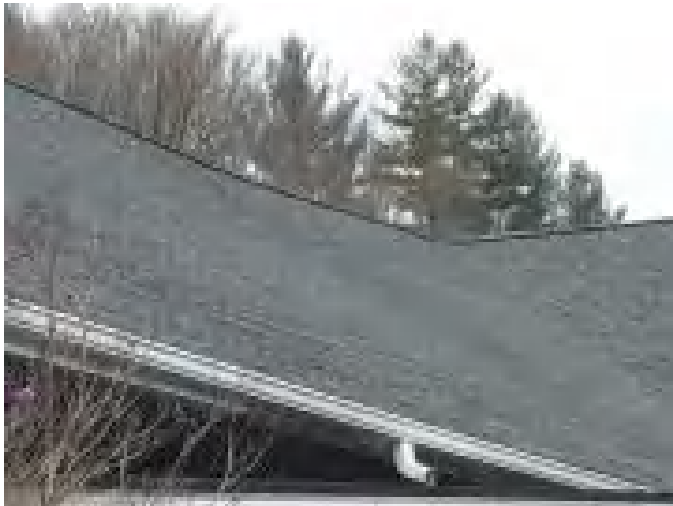
**System: B3010140 - Asphalt Shingles**

**Location:** Throughout  
**Distress:** Beyond Service Life  
**Category:** Deferred Maintenance / Appearance  
**Priority:** 3 - Necessary/Not Yet Critical (Years 2-5)  
**Correction:** Renew System  
**Qty:** 22,350.00  
**Unit of Measure:** S.F.  
**Estimate:** \$140,966.00  
**Assessor Name:** Terence Davis  
**Date Created:** 03/01/2017

**Notes:** The asphalt shingle roofing is aged, damaged and should be replaced.

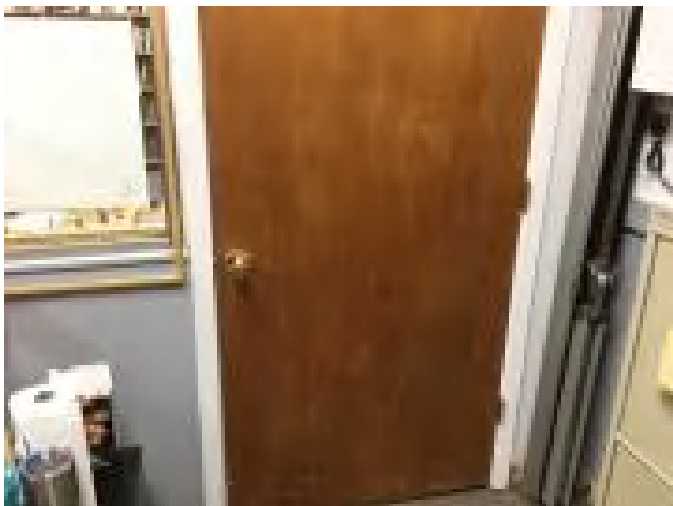
**System: C1020 - Interior Doors**

**Location:** Throughout  
**Distress:** Beyond Service Life  
**Category:** Deferred Maintenance / Accessibility Code Compliance  
**Priority:** 3 - Necessary/Not Yet Critical (Years 2-5)  
**Correction:** Renew System  
**Qty:** 22,350.00  
**Unit of Measure:** S.F.  
**Estimate:** \$63,675.00  
**Assessor Name:** Terence Davis  
**Date Created:** 01/27/2017

**Notes:** The interior doors are aged, failing, most hardware is not ADA or code compliant and should be replaced

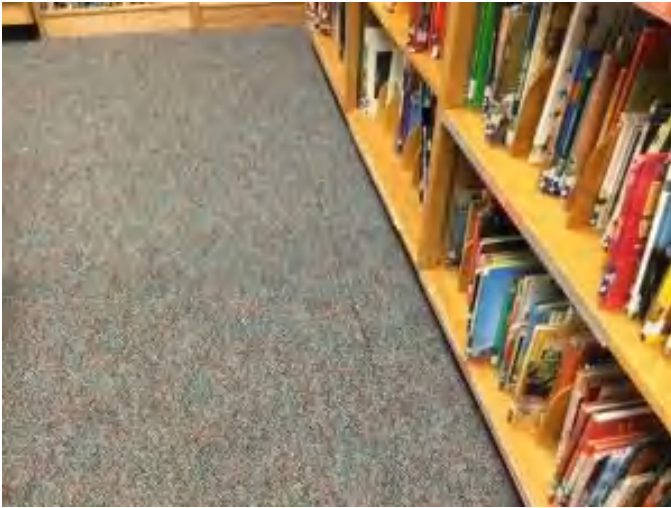
**System: C3020 - Floor Finishes**

**Location:** Throughout  
**Distress:** Failing  
**Category:** Deferred Maintenance / Appearance  
**Priority:** 3 - Necessary/Not Yet Critical (Years 2-5)  
**Correction:** Renew System  
**Qty:** 22,350.00  
**Unit of Measure:** S.F.  
**Estimate:** \$285,186.00  
**Assessor Name:** Terence Davis  
**Date Created:** 01/27/2017

**Notes:** The carpet is aged, stained, frayed, and should be replaced.  
The VCT flooring is aged, cracked, worn, and should be replaced.

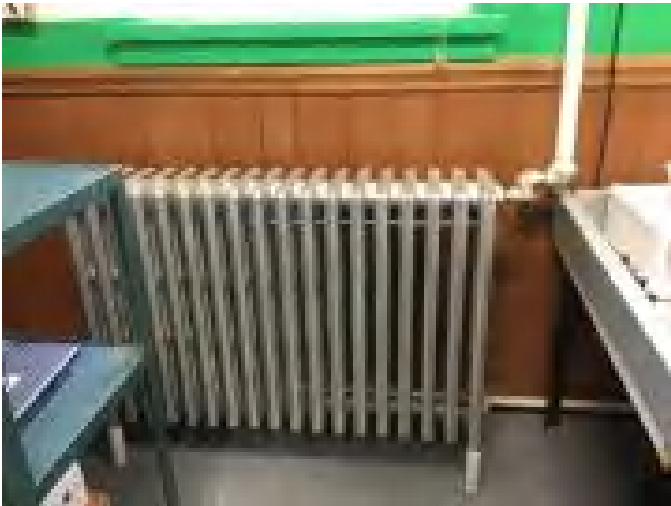
**System: D3040 - Distribution Systems**

**Location:** Throughout  
**Distress:** Beyond Service Life  
**Category:** Deferred Maintenance / Energy  
**Priority:** 3 - Necessary/Not Yet Critical (Years 2-5)  
**Correction:** Renew System  
**Qty:** 22,350.00  
**Unit of Measure:** S.F.  
**Estimate:** \$153,902.00  
**Assessor Name:** Terence Davis  
**Date Created:** 01/27/2017

**Notes:** The steam and hot water supply distribution system is aged, in marginal condition, and should be replaced.

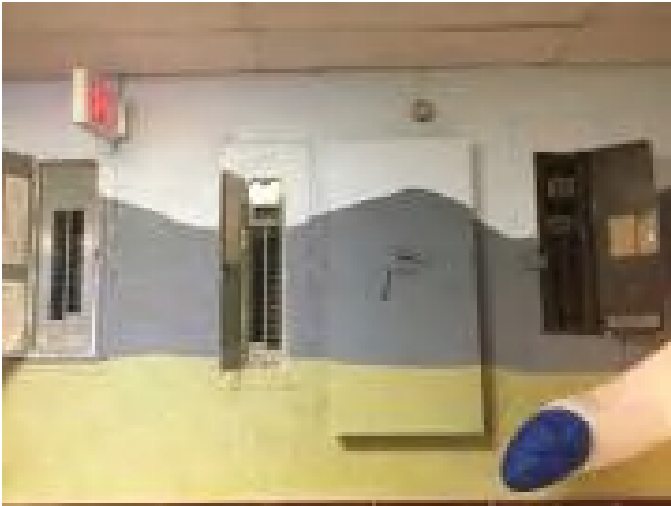
**System: D5010 - Electrical Service/Distribution**

**Location:** Throughout  
**Distress:** Beyond Service Life  
**Category:** Deferred Maintenance / Energy  
**Priority:** 3 - Necessary/Not Yet Critical (Years 2-5)  
**Correction:** Renew System  
**Qty:** 22,350.00  
**Unit of Measure:** S.F.  
**Estimate:** \$42,532.00  
**Assessor Name:** Terence Davis  
**Date Created:** 01/27/2017

**Notes:** The original electrical distribution system is operating properly due to an aggressive maintenance program but is aged, in marginal condition, and should be replaced.

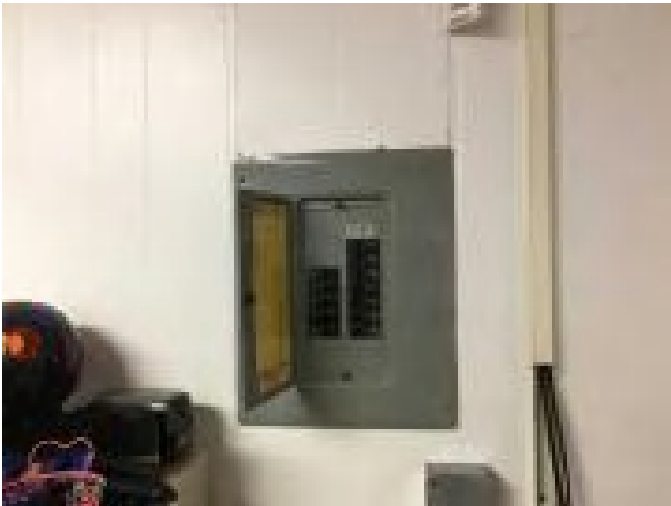
**System: D5020 - Branch Wiring**

**Location:** Throughout  
**Distress:** Beyond Service Life  
**Category:** Deferred Maintenance / Energy  
**Priority:** 3 - Necessary/Not Yet Critical (Years 2-5)  
**Correction:** Renew System  
**Qty:** 22,350.00  
**Unit of Measure:** S.F.  
**Estimate:** \$127,842.00  
**Assessor Name:** Terence Davis  
**Date Created:** 01/27/2017

**Notes:** The original branch wiring system is operating, but is aged, in poor condition, and should be replaced.

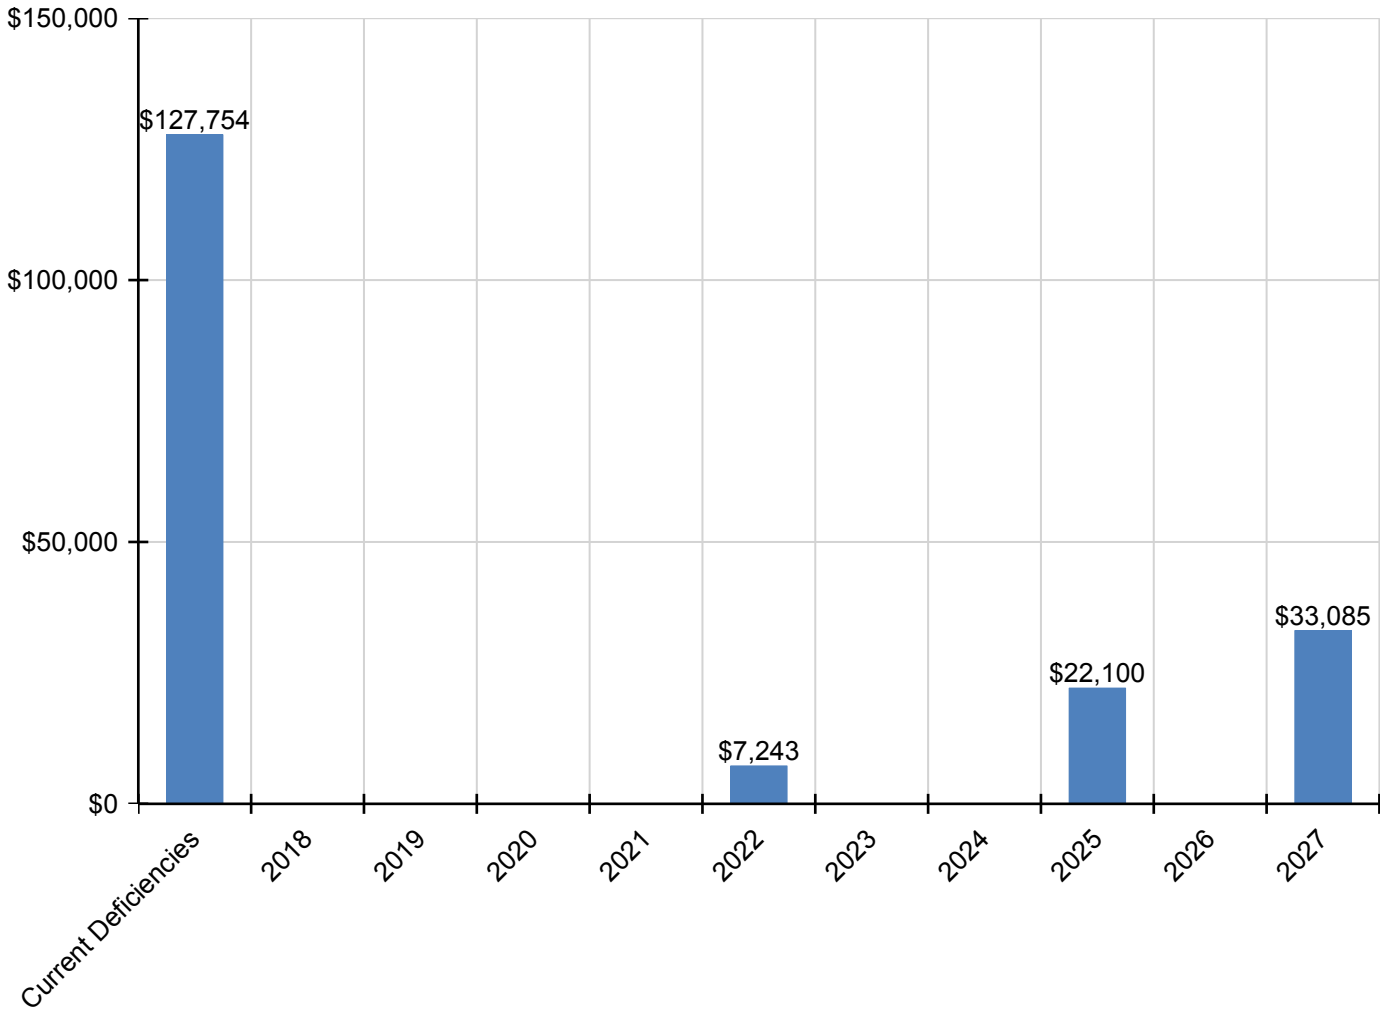
## Forecasted Capital Renewal Requirement

The following chart shows the current building deficiencies and forecasting capital renewal or sustainment requirements over the next ten years.

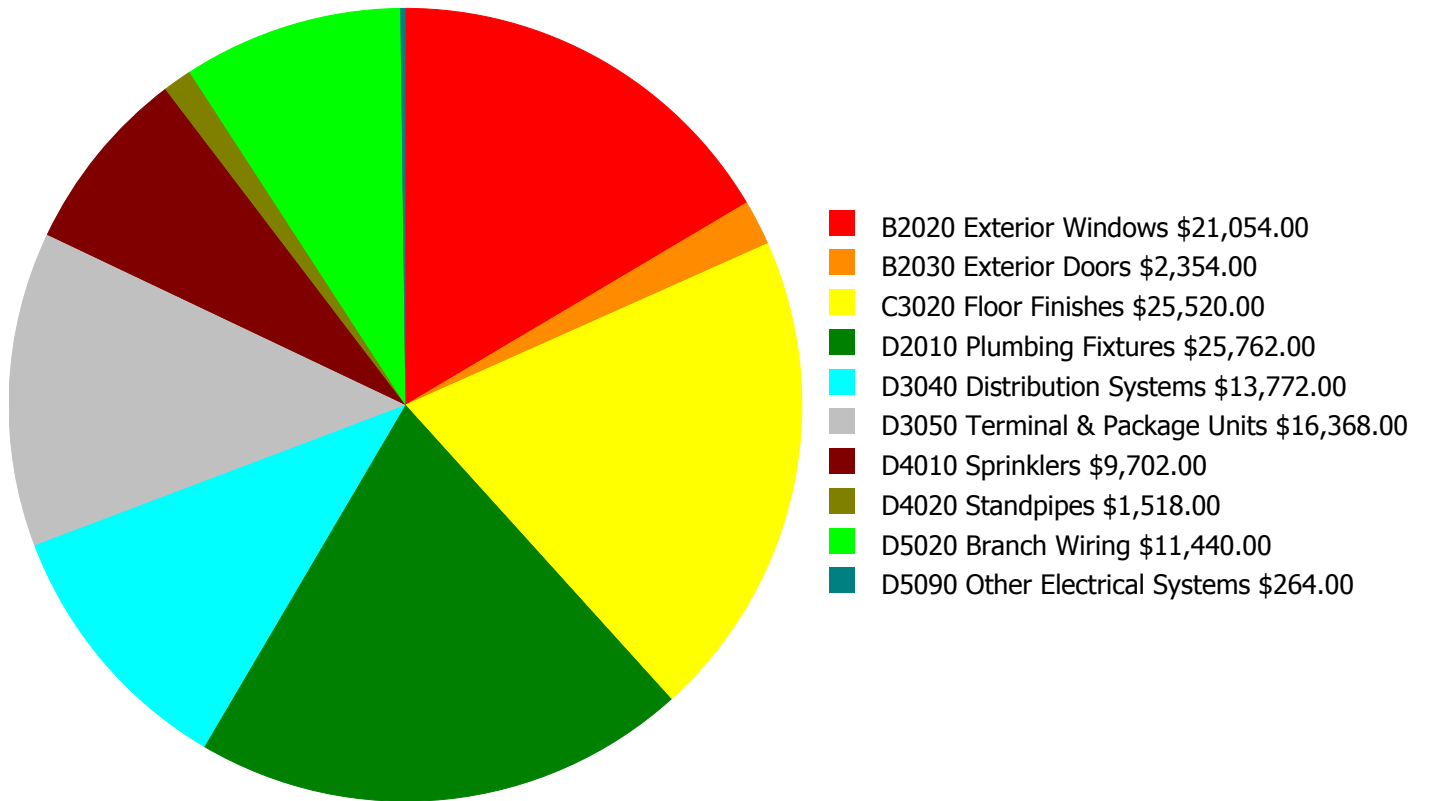
## Deficiency Summary by System

Current deficiencies included assemblies that have reached or exceeded their design life or components of the assemblies that are in need of repair. Assemblies that have reached their design life are identified as current deficiencies and assigned the distress 'Beyond Useful Life'. The following chart lists all current deficiencies associated with this facility.

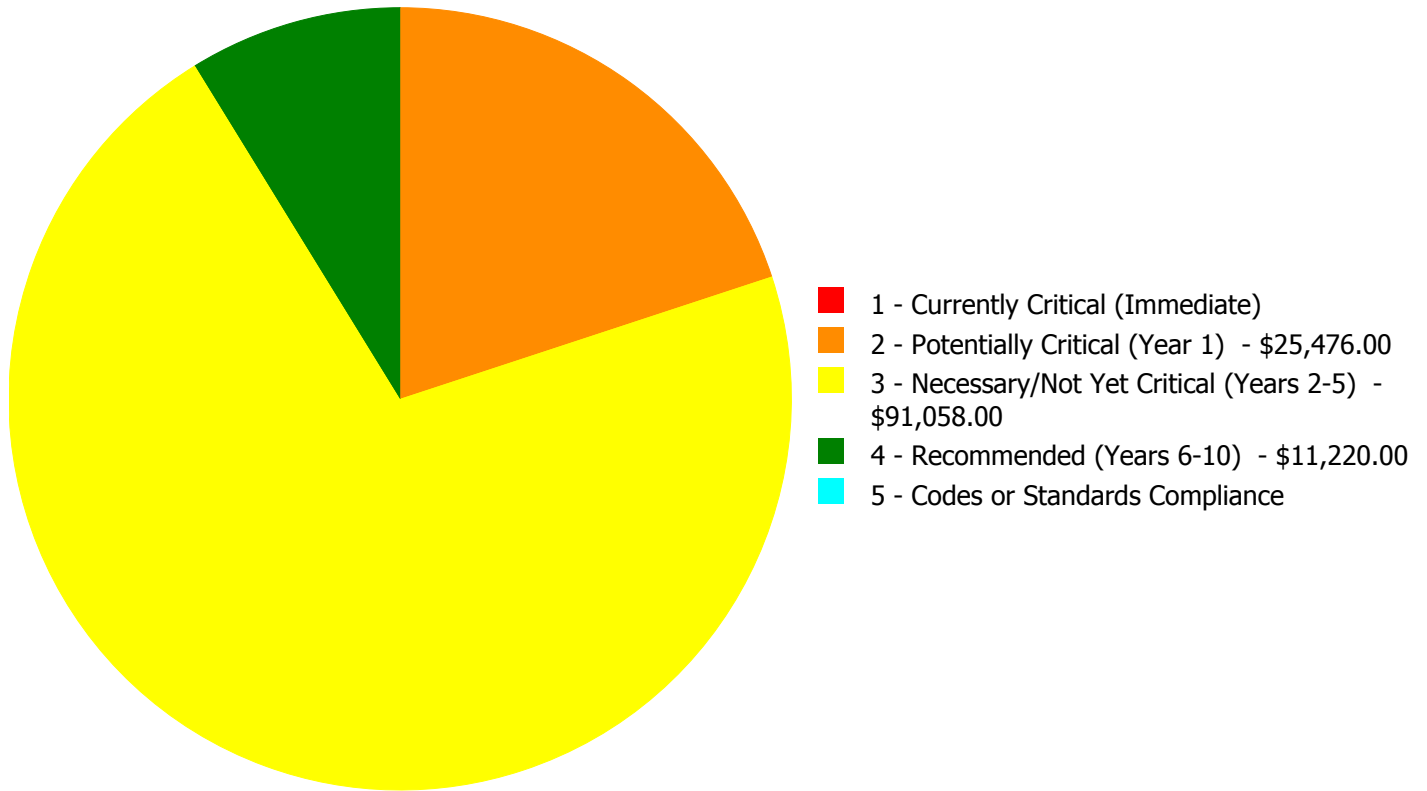
### Deficiency Summary by Priority

The following chart shows the total repair costs broken down by priority. Assessors assigned deficiencies within eCOMET to one of the following priority categories:

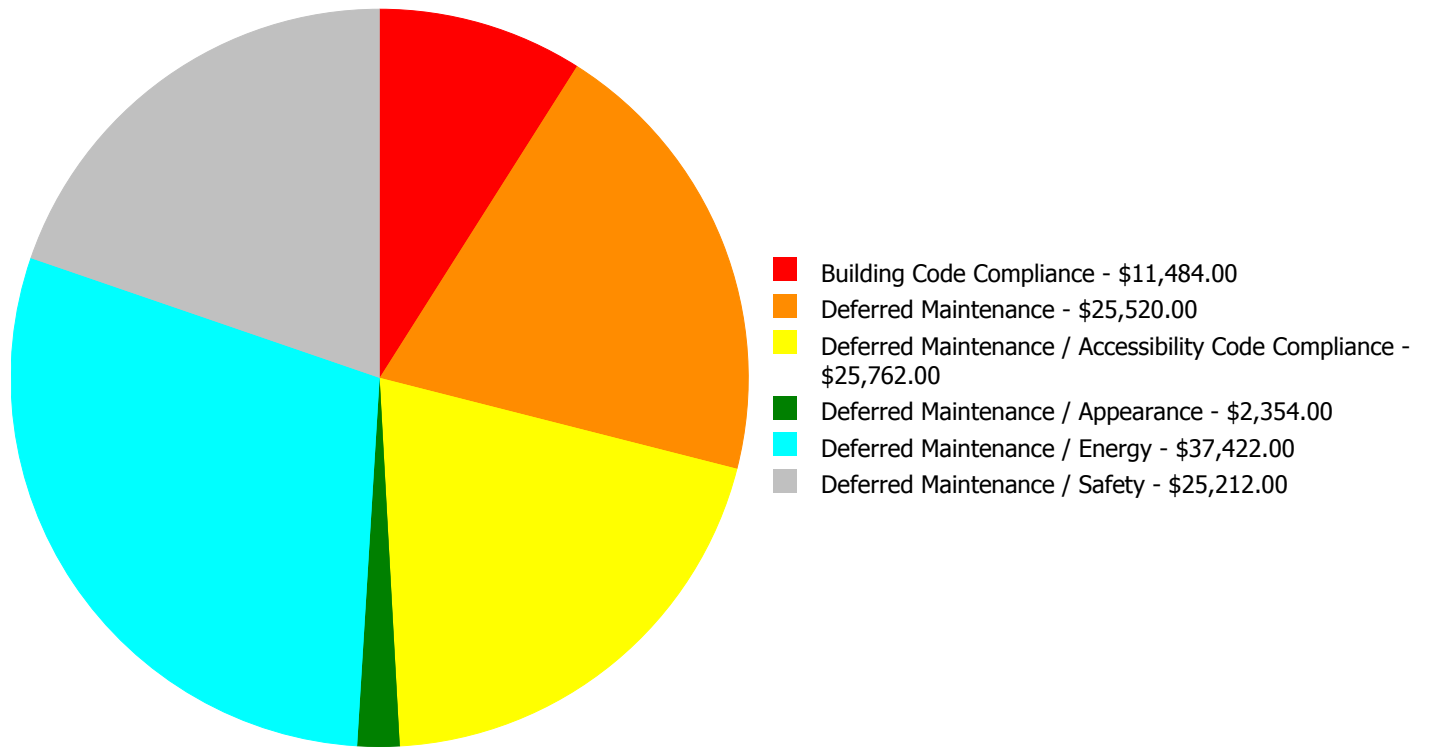
## Deficiency Summary by Category

The following chart shows the total repair costs broken down by deficiency categories. Assessors assigned deficiencies to one of the following categories:

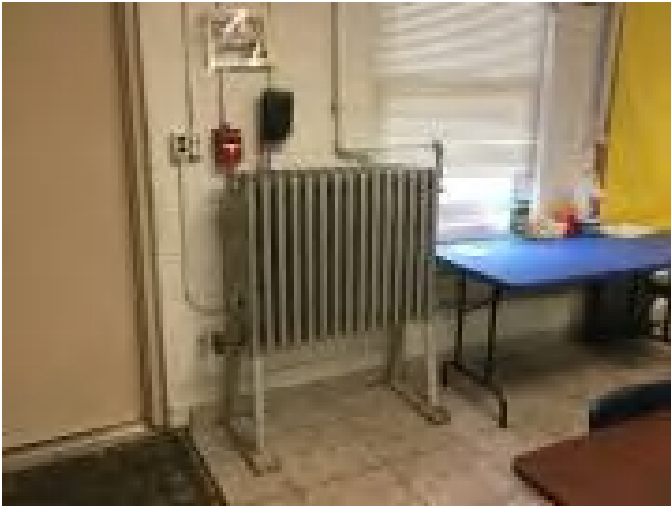
#### System: D3040 - Distribution Systems

**Location:** Throughout  
**Distress:** Failing  
**Category:** Deferred Maintenance / Safety  
**Priority:** 2 - Potentially Critical (Year 1)  
**Correction:** Renew System  
**Qty:** 2,000.00  
**Unit of Measure:** S.F.  
**Estimate:** \$13,772.00  
**Assessor Name:** Terence Davis  
**Date Created:** 01/27/2017

**Notes:** The radiators units are aged, becoming logistically unsupportable, and should be replaced.

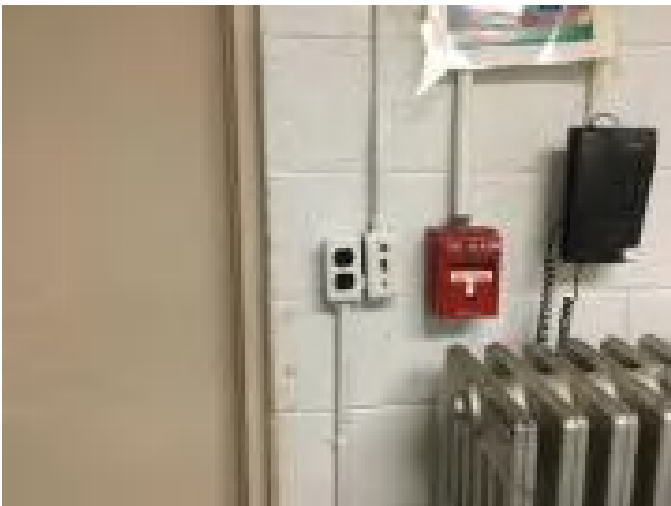
#### System: D5020 - Branch Wiring

**Location:** Throughout  
**Distress:** Beyond Service Life  
**Category:** Deferred Maintenance / Safety  
**Priority:** 2 - Potentially Critical (Year 1)  
**Correction:** Renew System  
**Qty:** 2,000.00  
**Unit of Measure:** S.F.  
**Estimate:** \$11,440.00  
**Assessor Name:** Terence Davis  
**Date Created:** 01/27/2017

**Notes:** The original branch wiring system is operating, but is aged, in poor condition, and should be replaced.

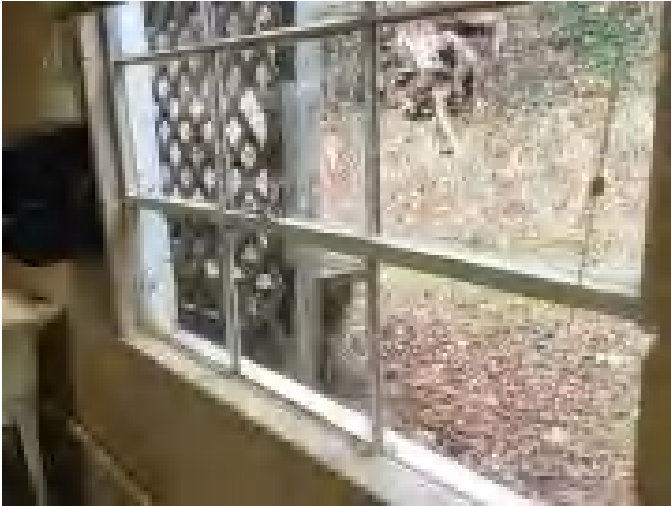
**System: B2020 - Exterior Windows**

**Location:** Throughout  
**Distress:** Beyond Service Life  
**Category:** Deferred Maintenance / Energy  
**Priority:** 3 - Necessary/Not Yet Critical (Years 2-5)  
**Correction:** Renew System  
**Qty:** 2,000.00  
**Unit of Measure:** S.F.  
**Estimate:** \$21,054.00  
**Assessor Name:** Terence Davis  
**Date Created:** 01/27/2017

**Notes:** The steel frame, operable, single pane windows are aged, rusted, not energy efficient, and should be replaced.

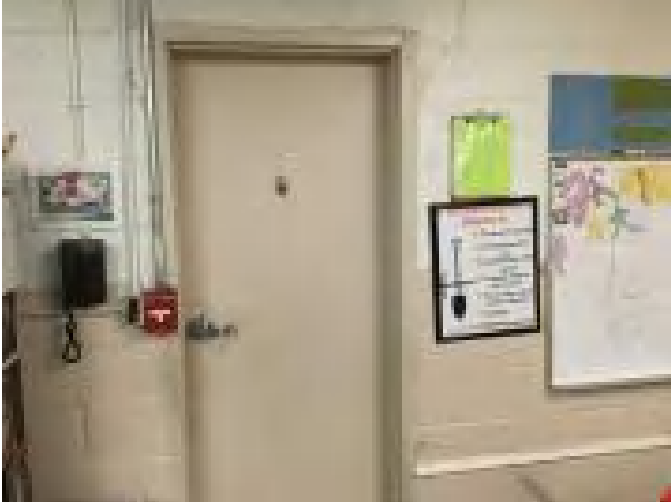
**System: B2030 - Exterior Doors**

**Location:** Throughout  
**Distress:** Beyond Service Life  
**Category:** Deferred Maintenance / Appearance  
**Priority:** 3 - Necessary/Not Yet Critical (Years 2-5)  
**Correction:** Renew System  
**Qty:** 2,000.00  
**Unit of Measure:** S.F.  
**Estimate:** \$2,354.00  
**Assessor Name:** Terence Davis  
**Date Created:** 01/27/2017

**Notes:** The original exterior doors are aged, rusted, and should be replaced.

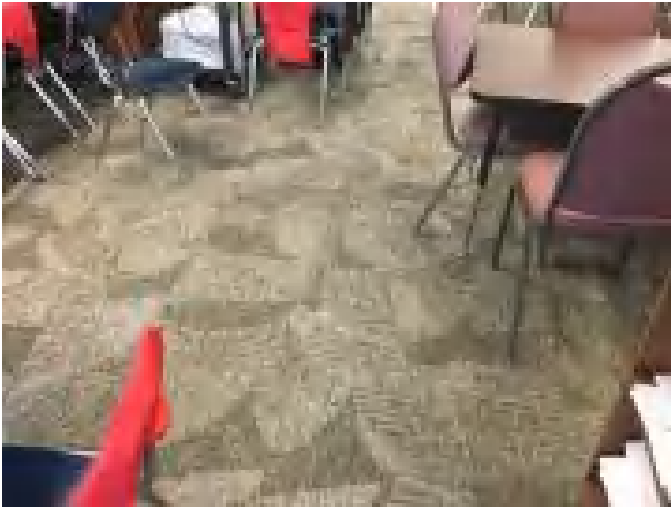
**System: C3020 - Floor Finishes**

**Location:** Throughout  
**Distress:** Beyond Service Life  
**Category:** Deferred Maintenance  
**Priority:** 3 - Necessary/Not Yet Critical (Years 2-5)  
**Correction:** Renew System  
**Qty:** 2,000.00  
**Unit of Measure:** S.F.  
**Estimate:** \$25,520.00  
**Assessor Name:** Terence Davis  
**Date Created:** 01/27/2017

**Notes:** The carpet is aged, stained, frayed, and should be replaced.

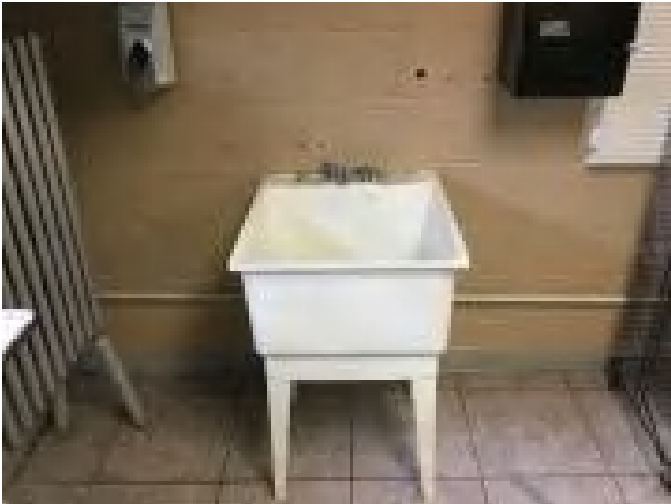
**System: D2010 - Plumbing Fixtures**

**Location:** Throughout  
**Distress:** Beyond Service Life  
**Category:** Deferred Maintenance / Accessibility Code Compliance  
**Priority:** 3 - Necessary/Not Yet Critical (Years 2-5)  
**Correction:** Renew System  
**Qty:** 2,000.00  
**Unit of Measure:** S.F.  
**Estimate:** \$25,762.00  
**Assessor Name:** Terence Davis  
**Date Created:** 01/27/2017

**Notes:** Plumbing fixtures are in operational conditions. However, they are aged, not ADA compliant and should be replaced with a low-flow water fixtures.

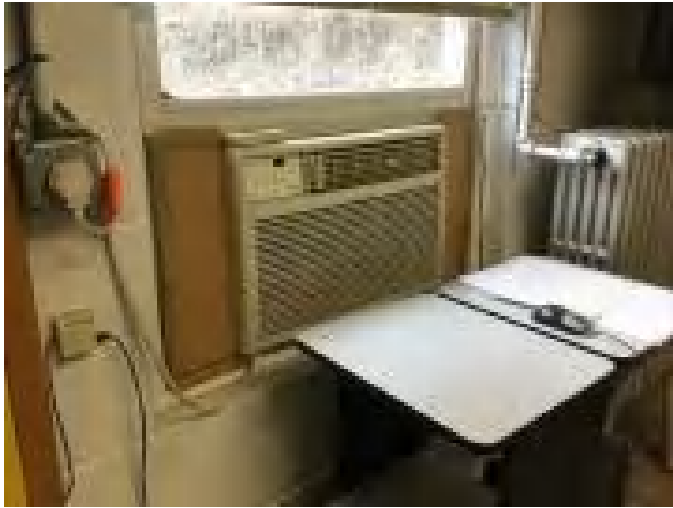
**System: D3050 - Terminal & Package Units**

**Location:** Throughout  
**Distress:** Beyond Service Life  
**Category:** Deferred Maintenance / Energy  
**Priority:** 3 - Necessary/Not Yet Critical (Years 2-5)  
**Correction:** Renew System  
**Qty:** 2,000.00  
**Unit of Measure:** S.F.  
**Estimate:** \$16,368.00  
**Assessor Name:** Terence Davis  
**Date Created:** 01/27/2017

**Notes:** The window mounted DX condensers are aged, rusted, not energy efficient, and should be replaced.
