NC School District/995 Yancey County/High School

# Mountain Heritage High

## Campus Assessment Report

March 7, 2017

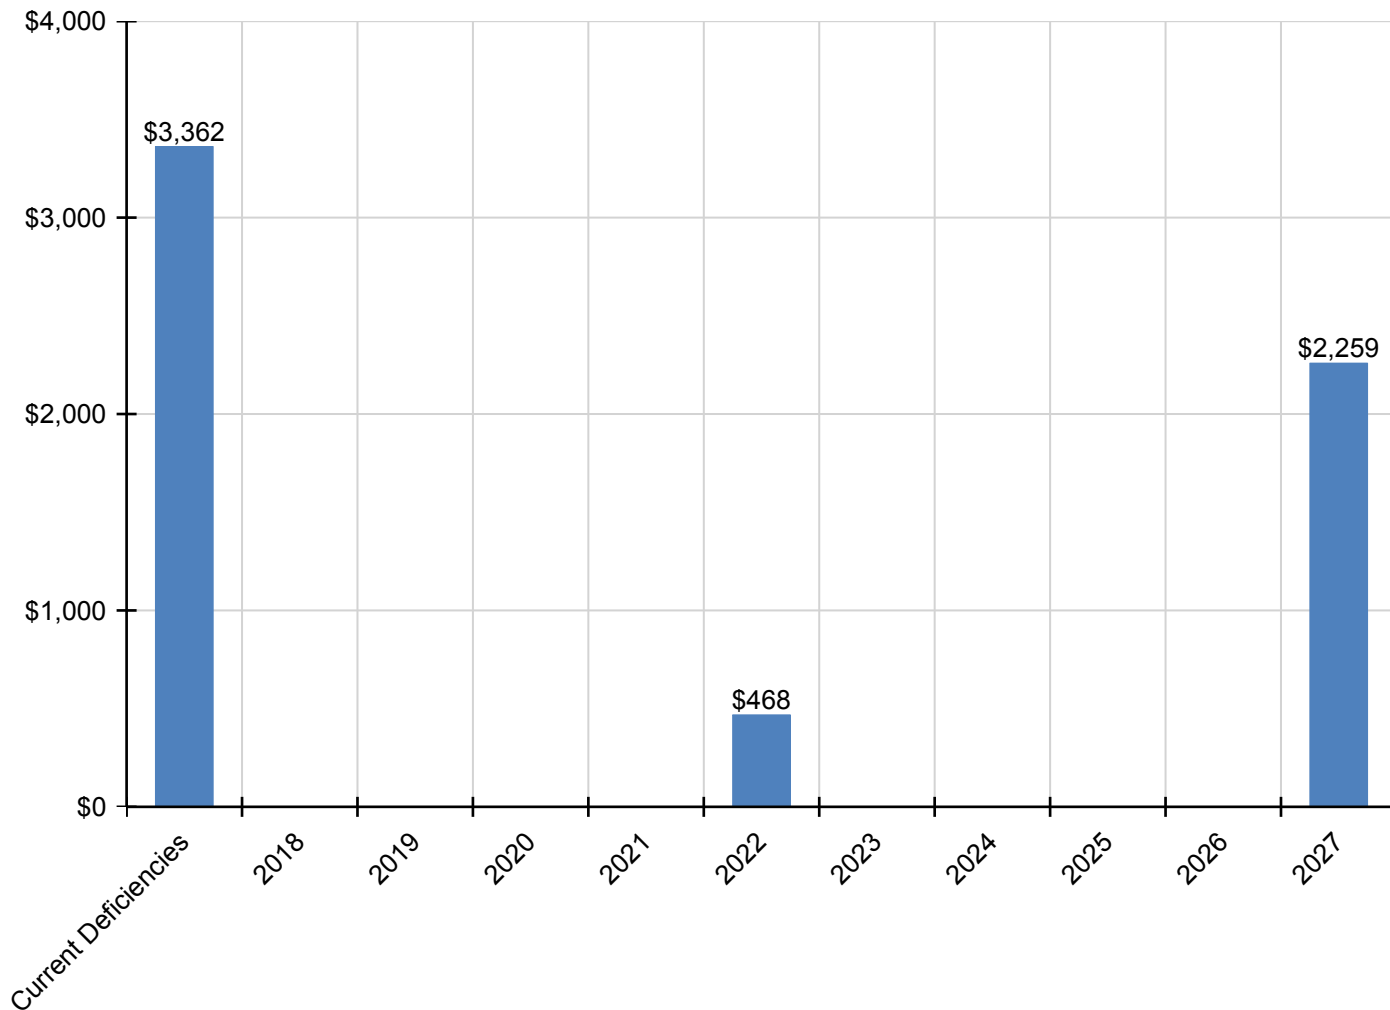
### Forecasted Capital Renewal Requirement

The following chart shows the current building deficiencies and forecasting capital renewal or sustainment requirements over the next ten years.

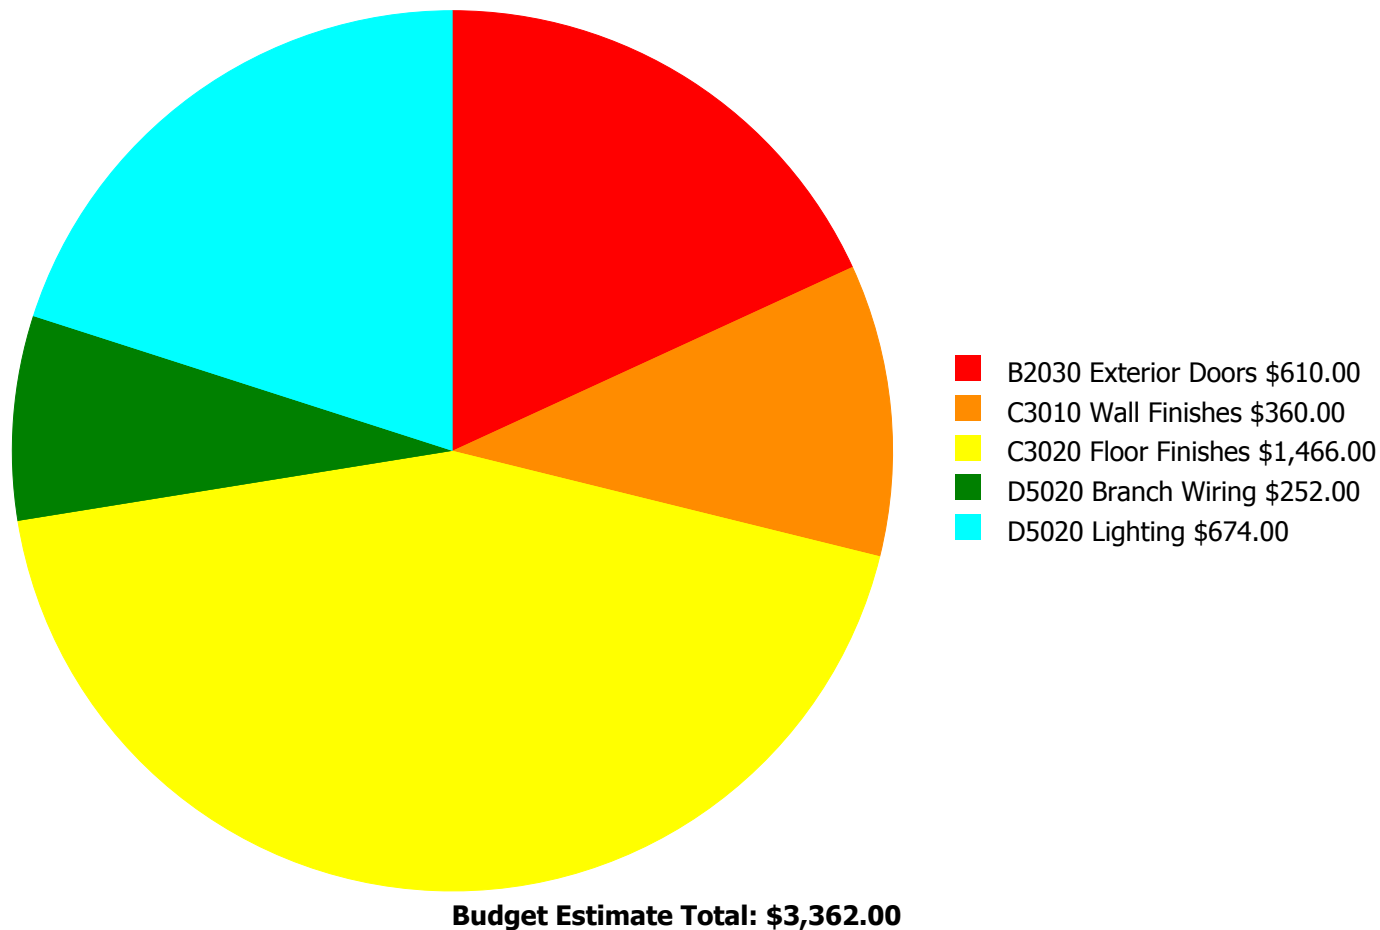
### Deficiency Summary by System

Current deficiencies included assemblies that have reached or exceeded their design life or components of the assemblies that are in need of repair. Assemblies that have reached their design life are identified as current deficiencies and assigned the distress 'Beyond Useful Life'. The following chart lists all current deficiencies associated with this facility.

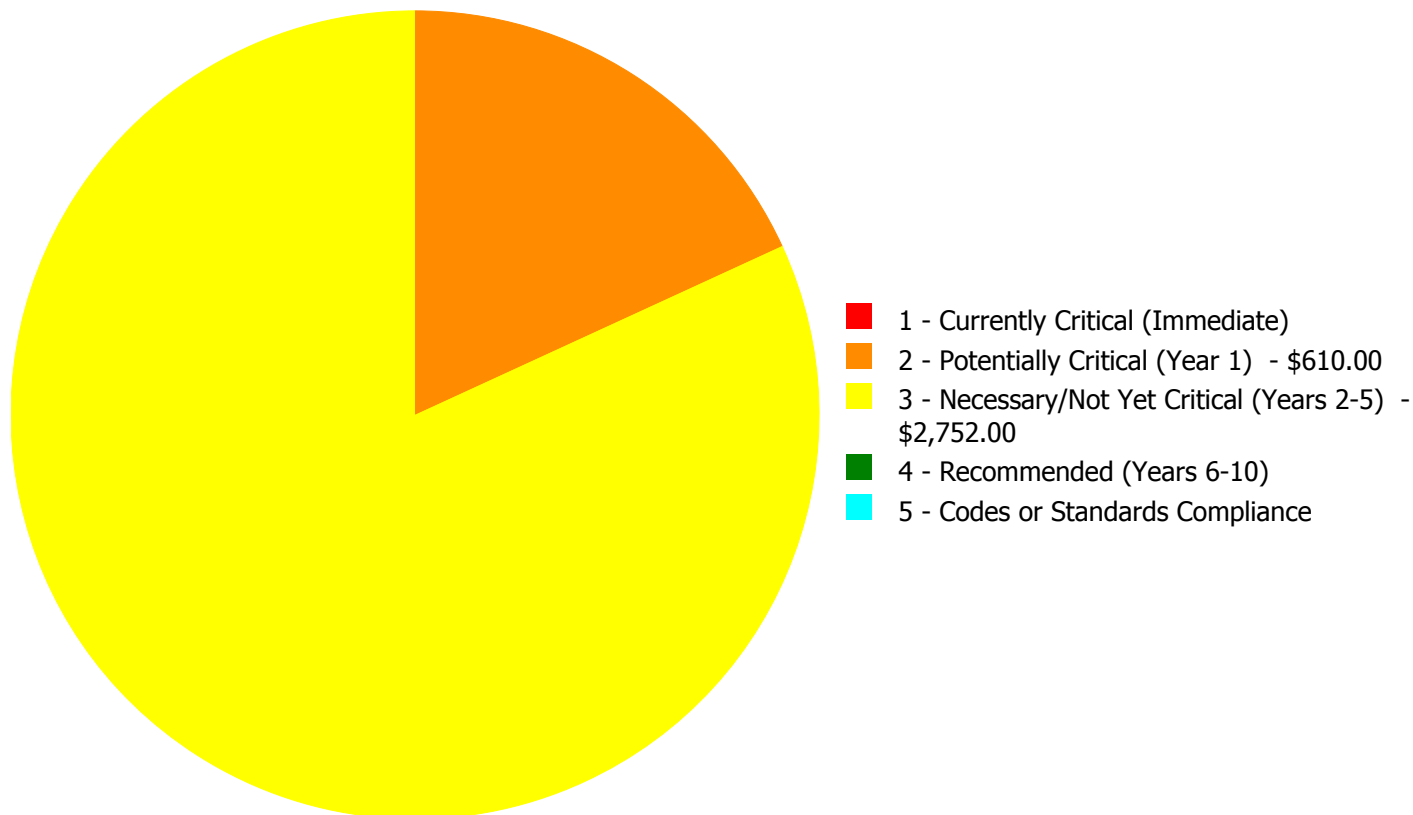
### Deficiency Summary by Priority

The following chart shows the total repair costs broken down by priority. Assessors assigned deficiencies within eCOMET to one of the following priority categories:

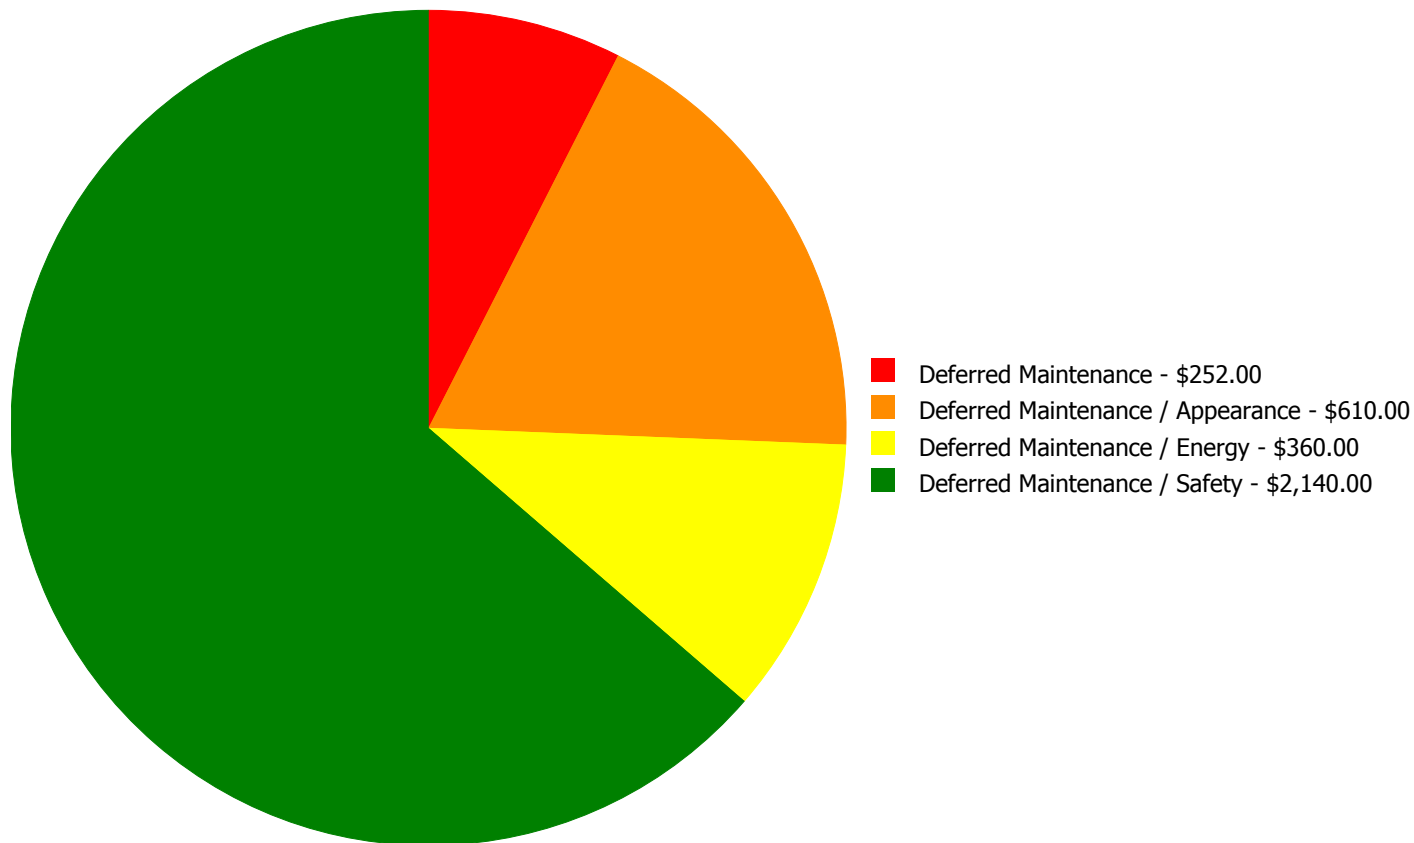
### Deficiency Summary by Category

The following chart shows the total repair costs broken down by deficiency categories. Assessors assigned deficiencies to one of the following categories:

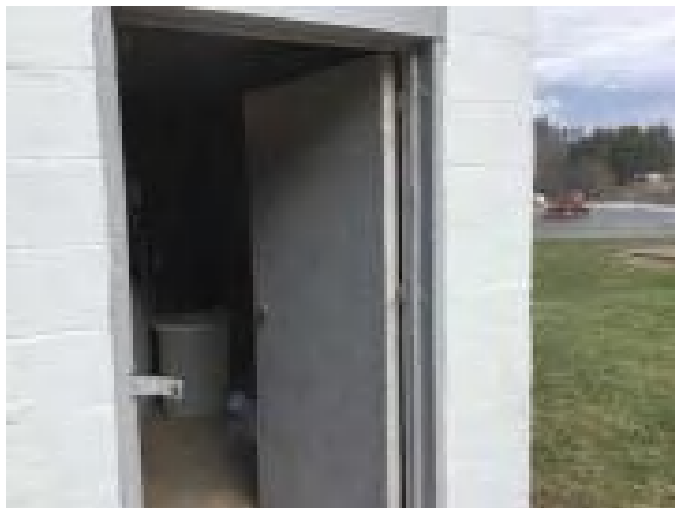
#### **System: B2030 - Exterior Doors**

**Location:** Entrance  
**Distress:** Failing  
**Category:** Deferred Maintenance / Appearance  
**Priority:** 2 - Potentially Critical (Year 1)  
**Correction:** Renew System  
**Qty:** 64.00  
**Unit of Measure:** S.F.  
**Estimate:** \$610.00  
**Assessor Name:** Eduardo Lopez  
**Date Created:** 01/27/2017

**Notes:** The original exterior door is failing and should be replaced.

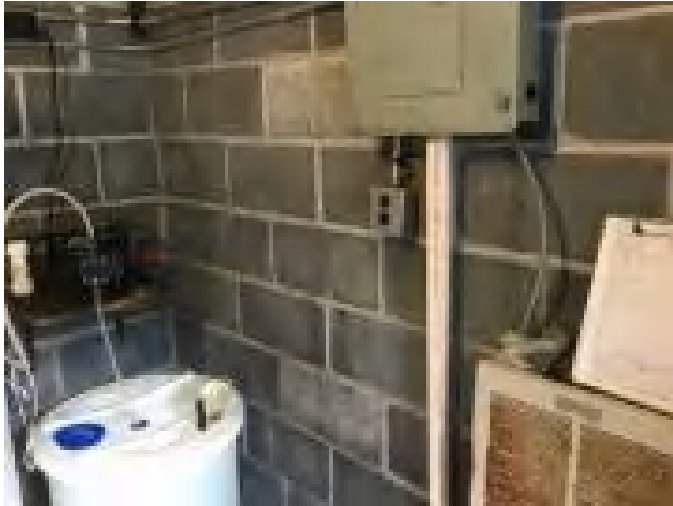
**System: C3010 - Wall Finishes**

**Location:** Throughout  
**Distress:** Inadequate  
**Category:** Deferred Maintenance / Energy  
**Priority:** 3 - Necessary/Not Yet Critical (Years 2-5)  
**Correction:** Renew System  
**Qty:** 64.00  
**Unit of Measure:** S.F.  
**Estimate:** \$360.00  
**Assessor Name:** Eduardo Lopez  
**Date Created:** 01/27/2017

**Notes:** Walls are in need of painting or sealing to aid in temperature control.

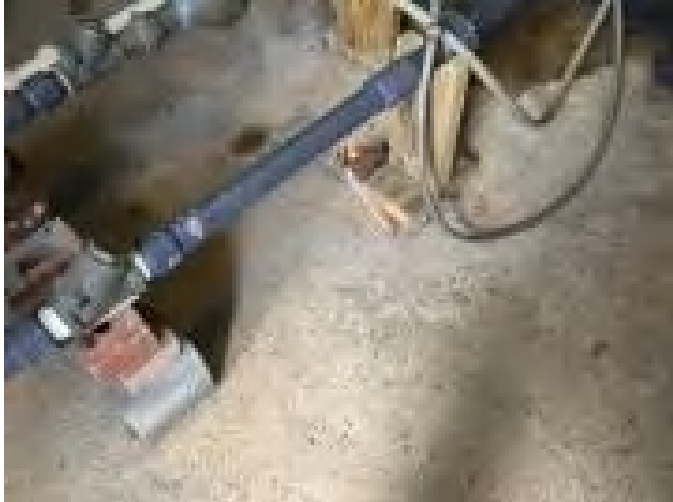
**System: C3020 - Floor Finishes**

**Location:** Throughout  
**Distress:** Inadequate  
**Category:** Deferred Maintenance / Safety  
**Priority:** 3 - Necessary/Not Yet Critical (Years 2-5)  
**Correction:** Renew System  
**Qty:** 64.00  
**Unit of Measure:** S.F.  
**Estimate:** \$1,466.00  
**Assessor Name:** Eduardo Lopez  
**Date Created:** 01/27/2017

**Notes:** The original flooring is in poor condition and should be re-sealed to protect the well equipment.

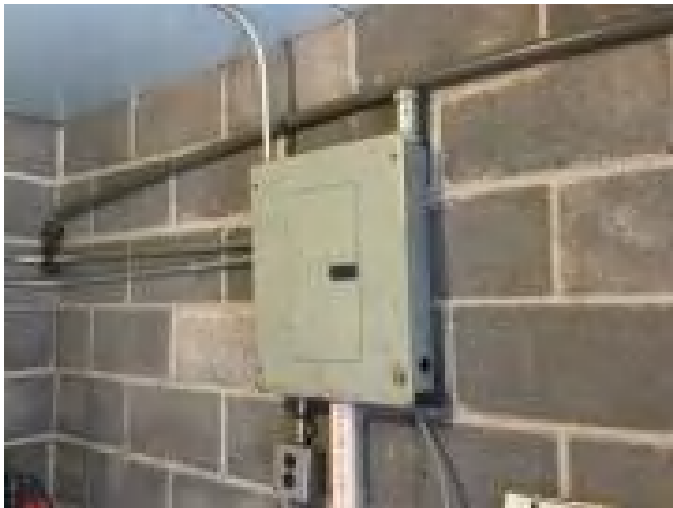
**System: D5020 - Branch Wiring**

**Location:** Throughout  
**Distress:** Beyond Service Life  
**Category:** Deferred Maintenance  
**Priority:** 3 - Necessary/Not Yet Critical (Years 2-5)  
**Correction:** Renew System  
**Qty:** 64.00  
**Unit of Measure:** S.F.  
**Estimate:** \$252.00  
**Assessor Name:** Eduardo Lopez  
**Date Created:** 01/27/2017

**Notes:** The original branch wiring system is operating, but is aged, in poor condition, and should be replaced.

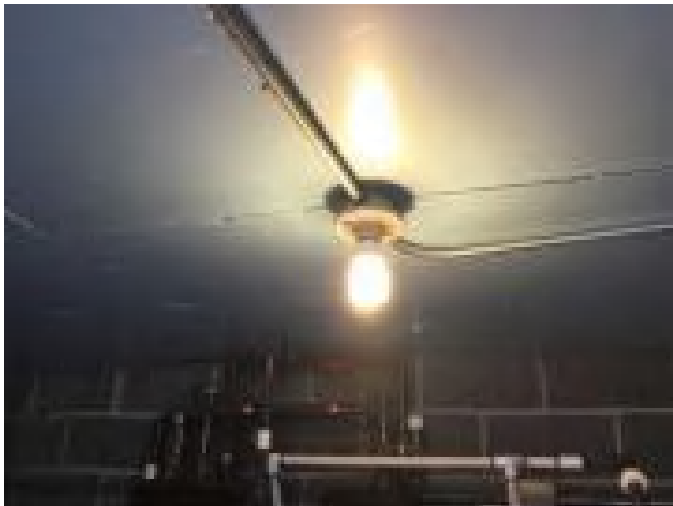
**System: D5020 - Lighting**

**Location:** Throughout  
**Distress:** Inadequate  
**Category:** Deferred Maintenance / Safety  
**Priority:** 3 - Necessary/Not Yet Critical (Years 2-5)  
**Correction:** Renew System  
**Qty:** 64.00  
**Unit of Measure:** S.F.  
**Estimate:** \$674.00  
**Assessor Name:** Eduardo Lopez  
**Date Created:** 01/27/2017

**Notes:** The original lighting system is operating, but is aged, in poor condition, and should be replaced.

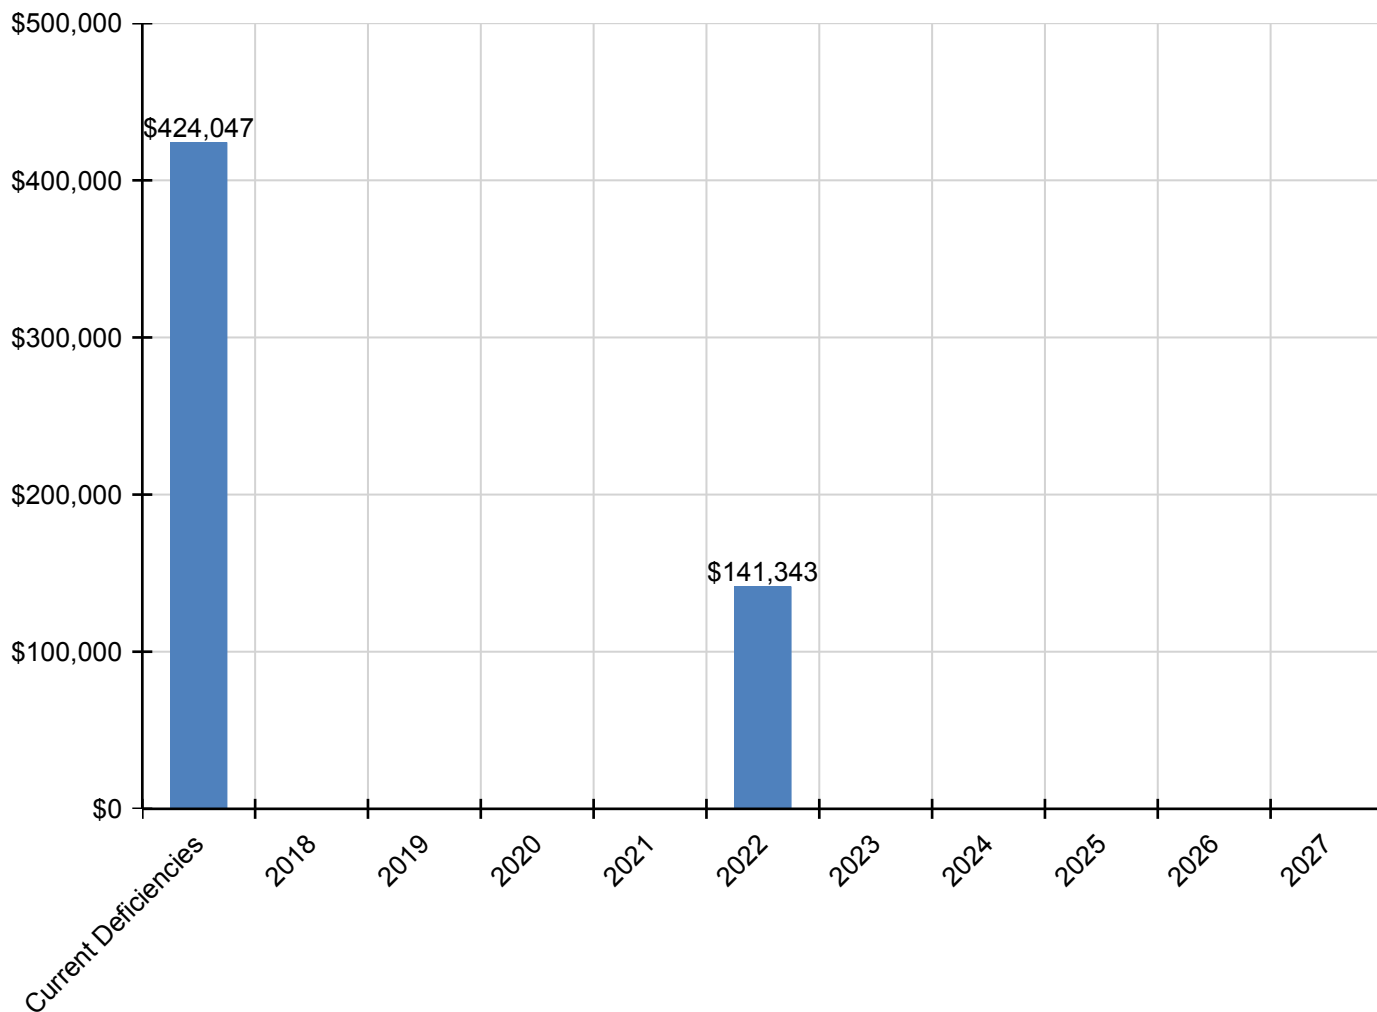
## Forecasted Capital Renewal Requirement

The following chart shows the current building deficiencies and forecasting capital renewal or sustainment requirements over the next ten years.

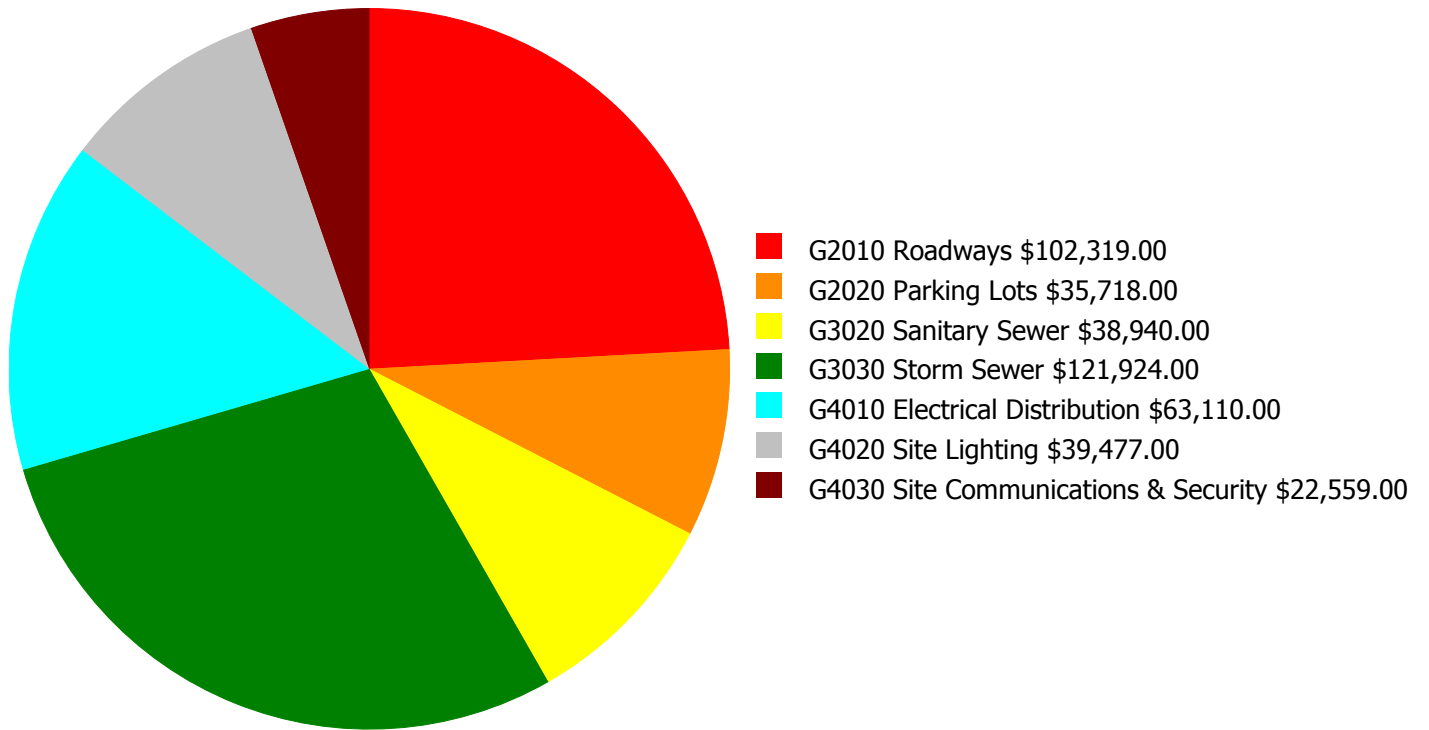
## Deficiency Summary by System

Current deficiencies included assemblies that have reached or exceeded their design life or components of the assemblies that are in need of repair. Assemblies that have reached their design life are identified as current deficiencies and assigned the distress 'Beyond Useful Life'. The following chart lists all current deficiencies associated with this facility.

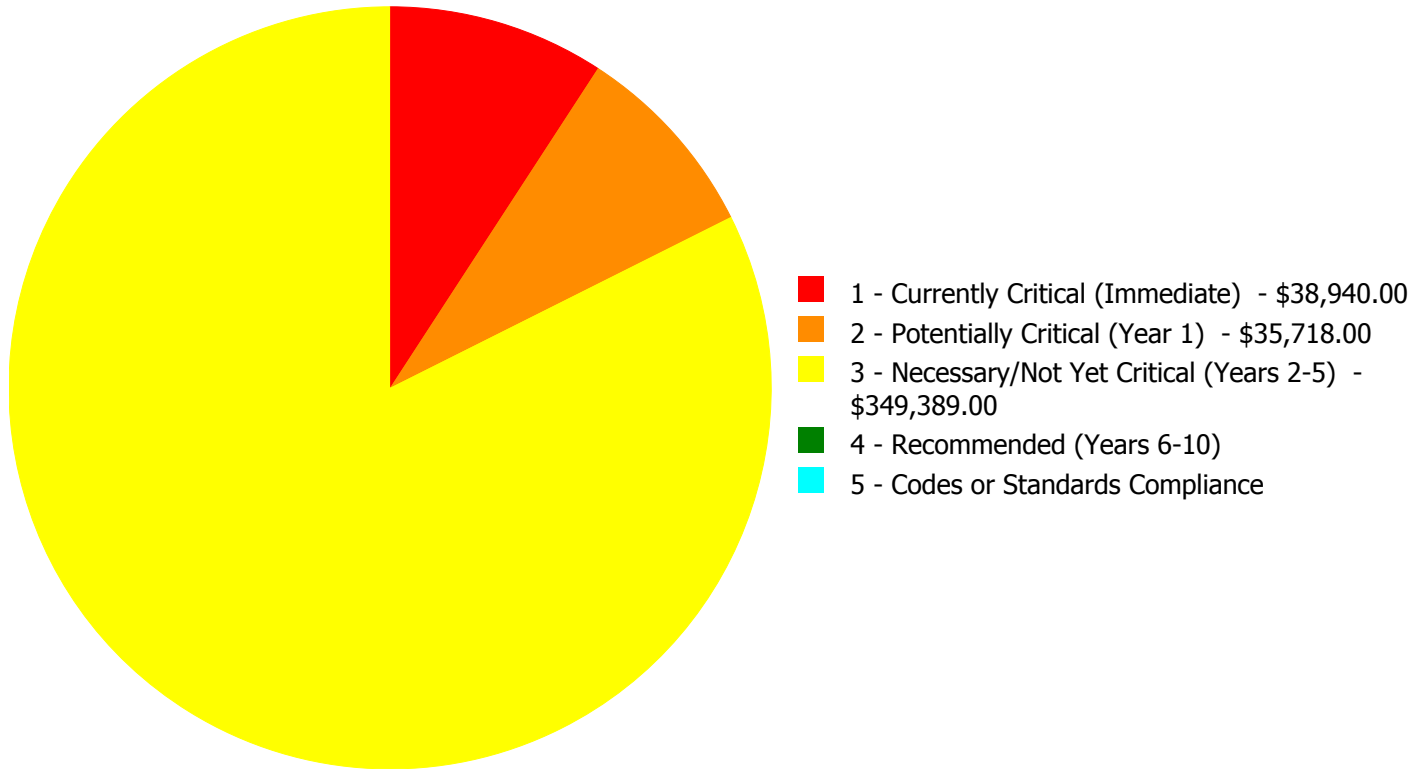
## Deficiency Summary by Priority

The following chart shows the total repair costs broken down by priority. Assessors assigned deficiencies within eCOMET to one of the following priority categories:

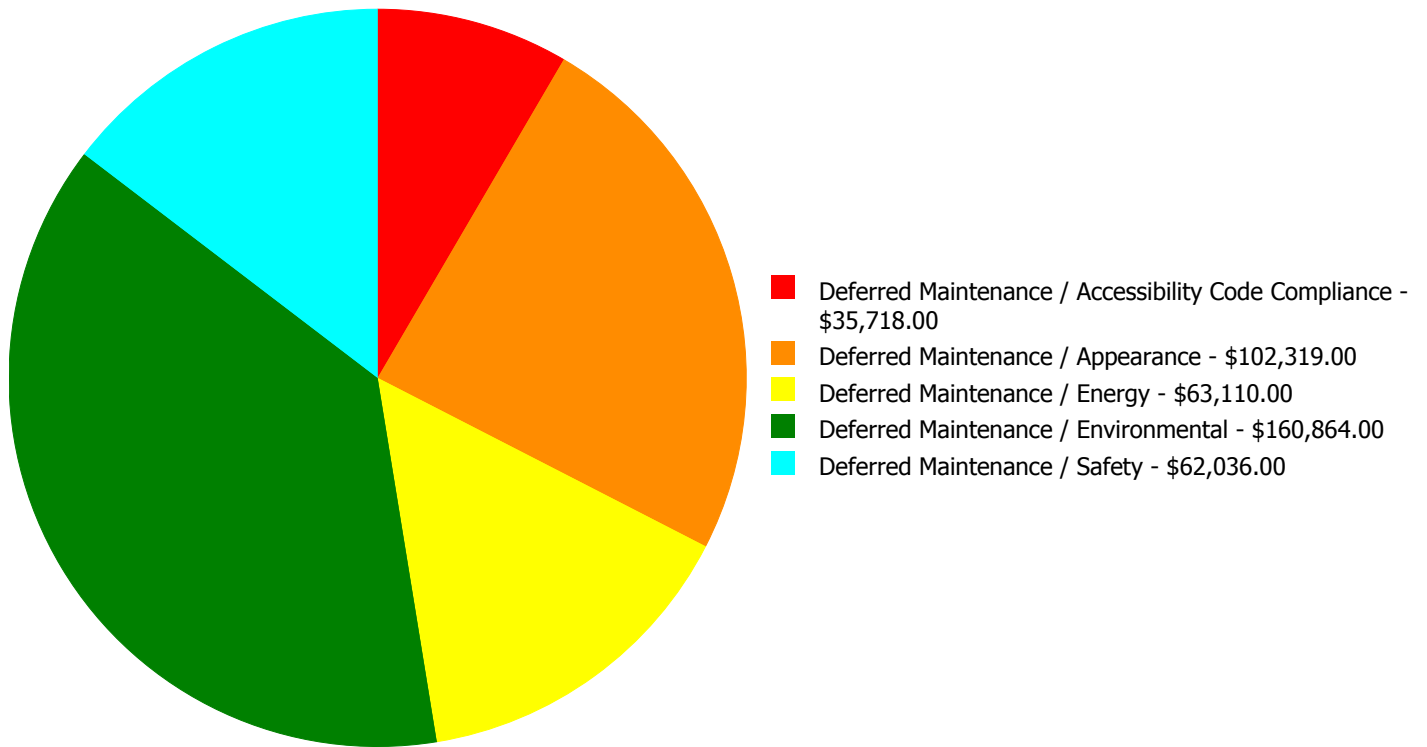
## Deficiency Summary by Category

The following chart shows the total repair costs broken down by deficiency categories. Assessors assigned deficiencies to one of the following categories:

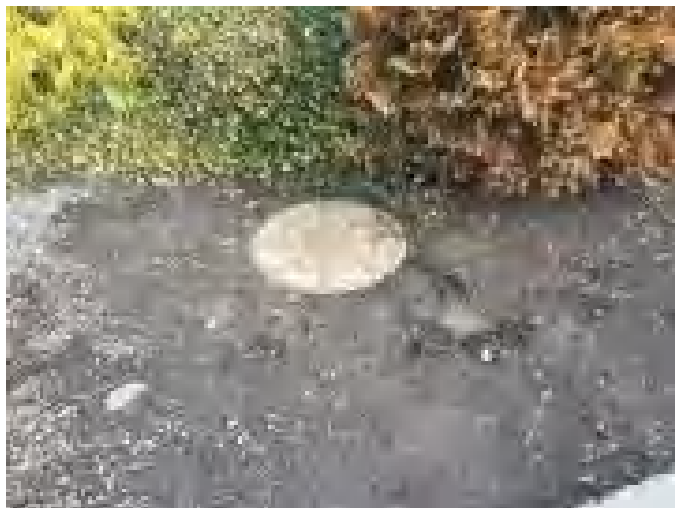
#### System: G3020 - Sanitary Sewer

**Location:** Septic  
**Distress:** Failing  
**Category:** Deferred Maintenance / Environmental  
**Priority:** 1 - Currently Critical (Immediate)  
**Correction:** Renew System  
**Qty:** 24,414.00  
**Unit of Measure:** S.F.  
**Estimate:** \$38,940.00  
**Assessor Name:** Eduardo Lopez  
**Date Created:** 01/27/2017

**Notes:** The sanitary waste system requires daily pump-out, is aged, and should be replaced.

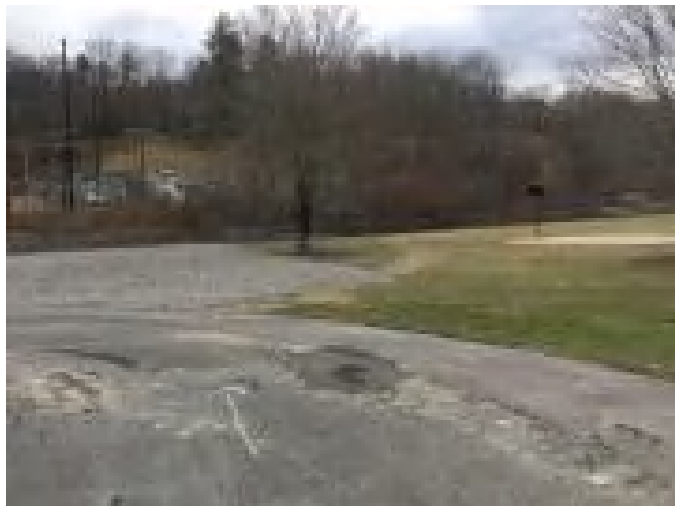
**System: G2020 - Parking Lots**

**Location:** Parking  
**Distress:** Failing  
**Category:** Deferred Maintenance / Accessibility Code Compliance  
**Priority:** 2 - Potentially Critical (Year 1)  
**Correction:** Renew System  
**Qty:** 24,414.00  
**Unit of Measure:** S.F.  
**Estimate:** \$35,718.00  
**Assessor Name:** Eduardo Lopez  
**Date Created:** 01/27/2017

**Notes:** The parking lot is aged, has many repairs and potholes, and should be replaced and re-striped. ADA signs height needs to be adjusted per minimum ADA standards.

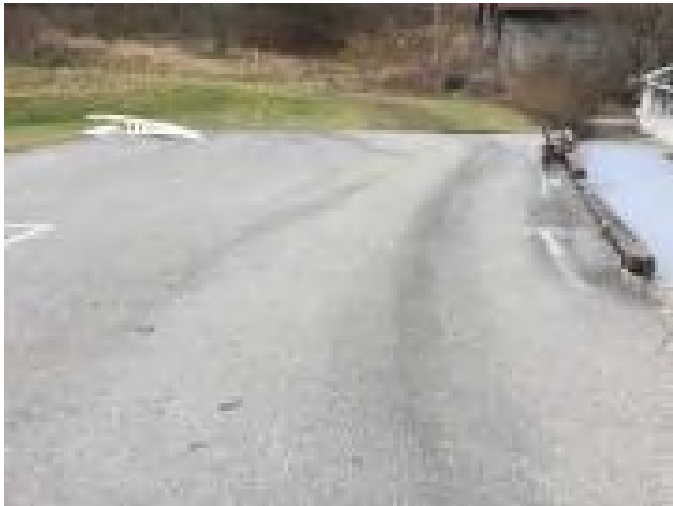
**System: G2010 - Roadways**

**Location:** Site entrance  
**Distress:** Beyond Service Life  
**Category:** Deferred Maintenance / Appearance  
**Priority:** 3 - Necessary/Not Yet Critical (Years 2-5)  
**Correction:** Renew System  
**Qty:** 24,414.00  
**Unit of Measure:** S.F.  
**Estimate:** \$102,319.00  
**Assessor Name:** Eduardo Lopez  
**Date Created:** 01/27/2017

**Notes:** The asphaltic roadway is aged, has many road cuts and repairs, and should be re-surfaced.

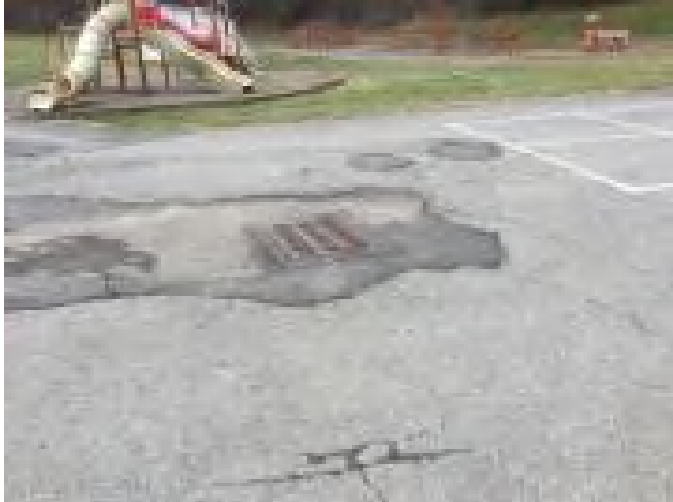
**System: G3030 - Storm Sewer**

**Location:** Throughout  
**Distress:** Beyond Service Life  
**Category:** Deferred Maintenance / Environmental  
**Priority:** 3 - Necessary/Not Yet Critical (Years 2-5)  
**Correction:** Renew System  
**Qty:** 24,414.00  
**Unit of Measure:** S.F.  
**Estimate:** \$121,924.00  
**Assessor Name:** Eduardo Lopez  
**Date Created:** 01/27/2017

**Notes:** The storm sewer system is aged, in marginal condition, and should be replaced.

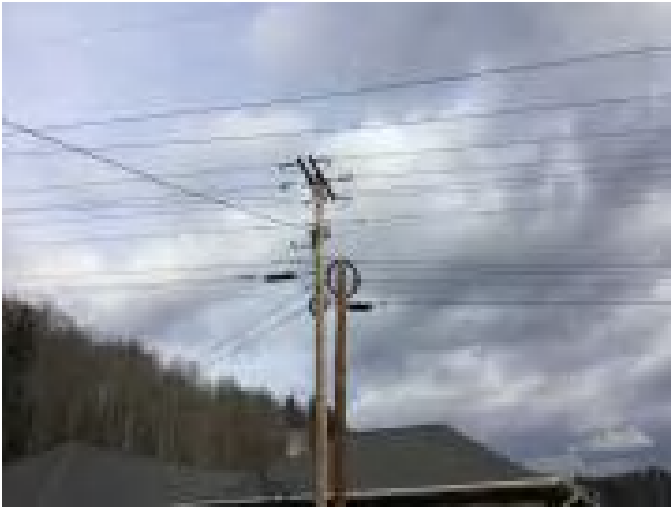
**System: G4010 - Electrical Distribution**

**Location:** Throughout  
**Distress:** Beyond Service Life  
**Category:** Deferred Maintenance / Energy  
**Priority:** 3 - Necessary/Not Yet Critical (Years 2-5)  
**Correction:** Renew System  
**Qty:** 24,414.00  
**Unit of Measure:** S.F.  
**Estimate:** \$63,110.00  
**Assessor Name:** Eduardo Lopez  
**Date Created:** 01/27/2017

**Notes:** The original electrical distribution system is operating properly due to an aggressive maintenance program but is aged, in marginal condition, and should be replaced.

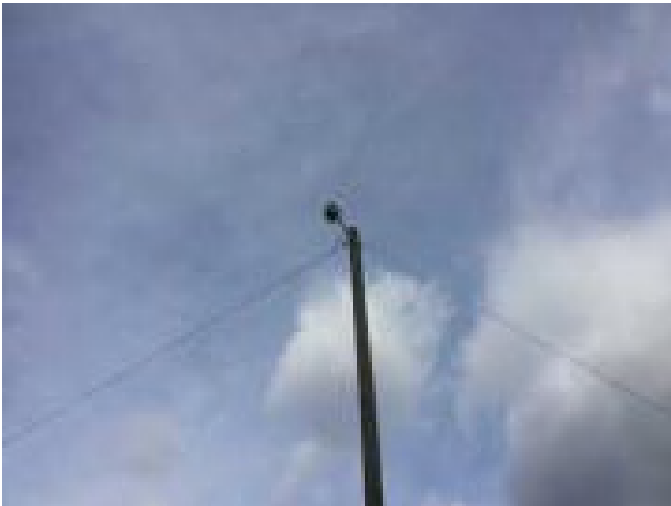
**System: G4020 - Site Lighting**

**Location:** Throughout  
**Distress:** Inadequate  
**Category:** Deferred Maintenance / Safety  
**Priority:** 3 - Necessary/Not Yet Critical (Years 2-5)  
**Correction:** Renew System  
**Qty:** 24,414.00  
**Unit of Measure:** S.F.  
**Estimate:** \$39,477.00  
**Assessor Name:** Eduardo Lopez  
**Date Created:** 01/27/2017

**Notes:** Site lighting is aged and inadequate and does not cover all areas and should be replaced.

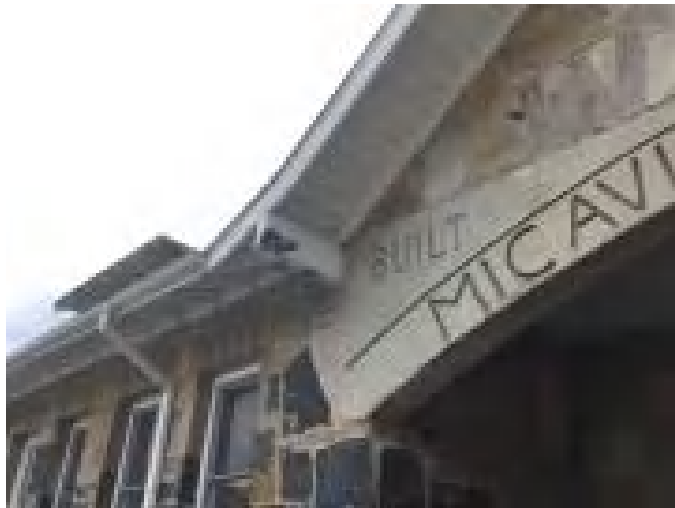
**System: G4030 - Site Communications & Security**

**Location:** Throughout  
**Distress:** Inadequate  
**Category:** Deferred Maintenance / Safety  
**Priority:** 3 - Necessary/Not Yet Critical (Years 2-5)  
**Correction:** Renew System  
**Qty:** 24,414.00  
**Unit of Measure:** S.F.  
**Estimate:** \$22,559.00  
**Assessor Name:** Eduardo Lopez  
**Date Created:** 01/27/2017

**Notes:** Site security is inadequate and should be upgraded.

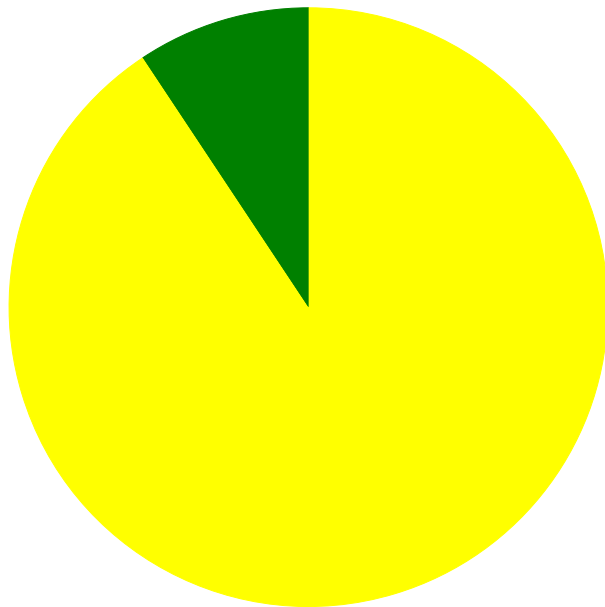
### Deficiencies By Priority

- 1 - Currently Critical (Immediate)
- 2 - Potentially Critical (Year 1)
- 3 - Necessary/Not Yet Critical (Years 2-5) - \$1,229,327.00
- 4 - Recommended (Years 6-10) - \$126,472.00
- 5 - Codes or Standards Compliance

**Budget Estimate Total: \$1,355,799.00**

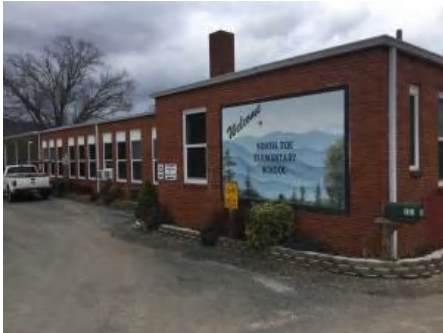
1). South Elevation - Feb 01, 2017

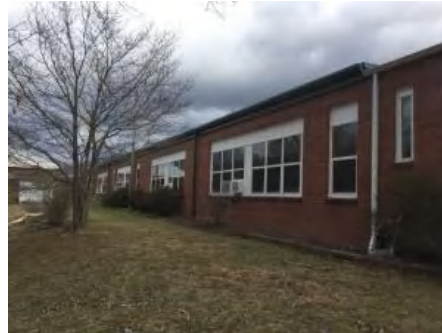
2). West Elevation - Feb 01, 2017

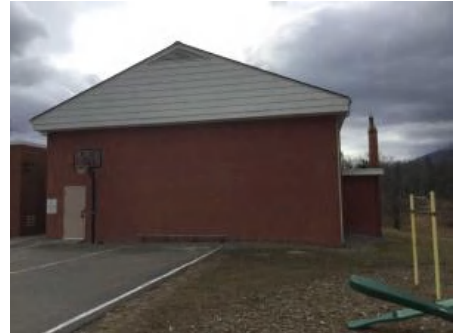
3). North Elevation - Feb 01, 2017

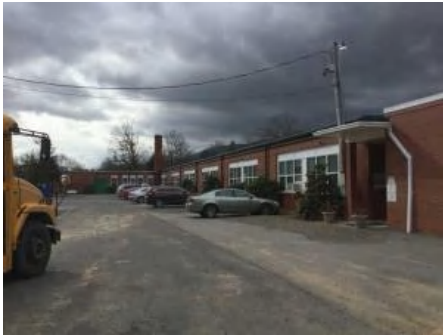
4). East Elevation - Feb 01, 2017

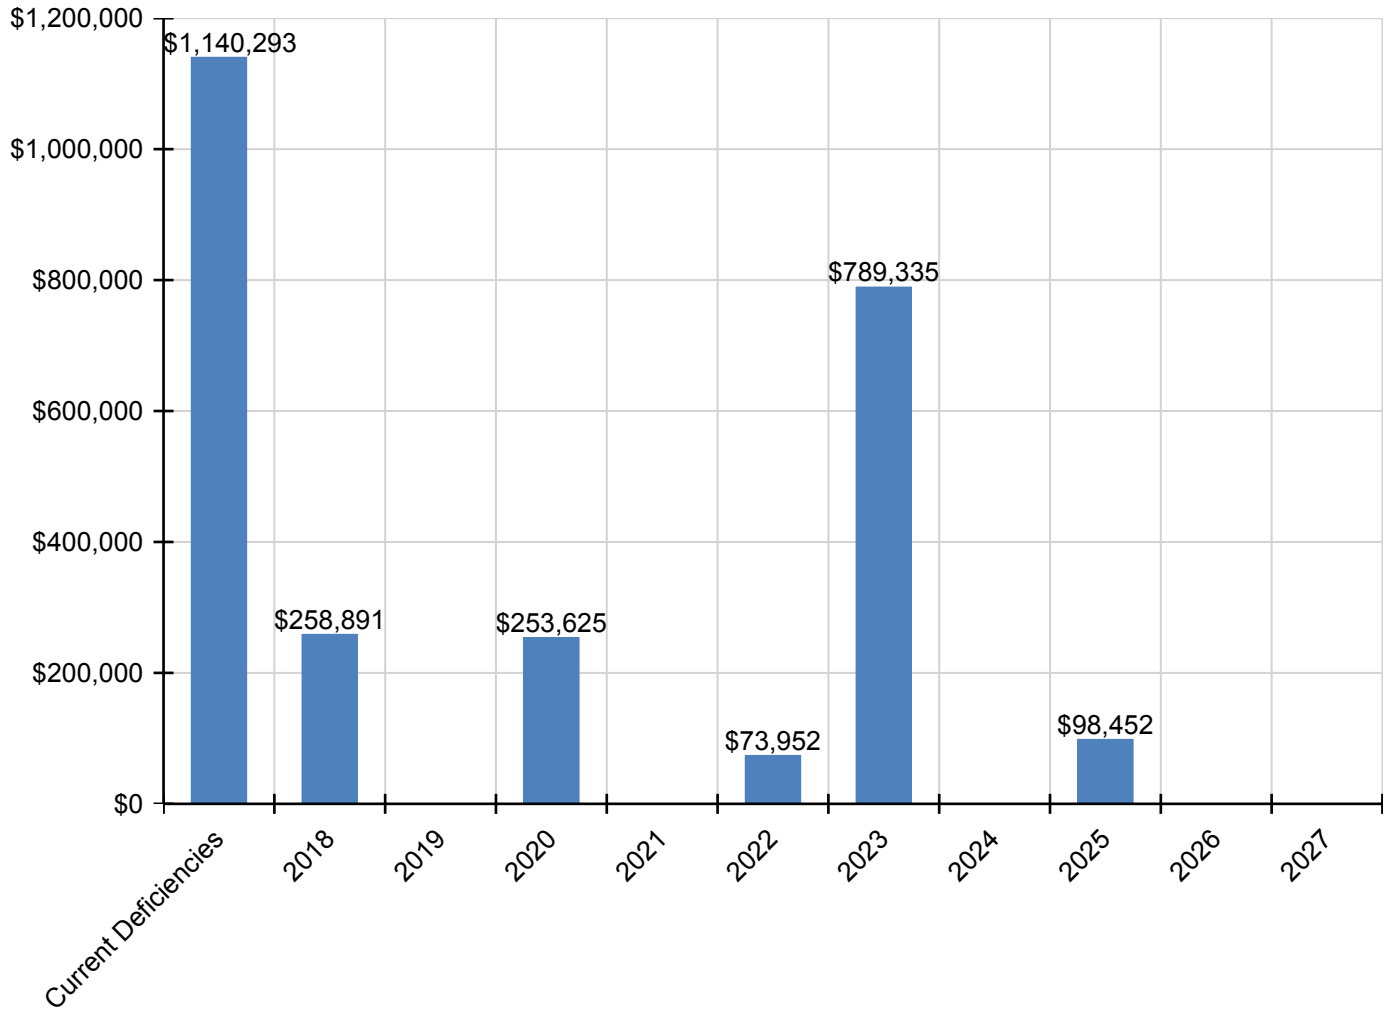
## Forecasted Capital Renewal Requirement

The following chart shows the current building deficiencies and forecasting capital renewal or sustainment requirements over the next ten years.

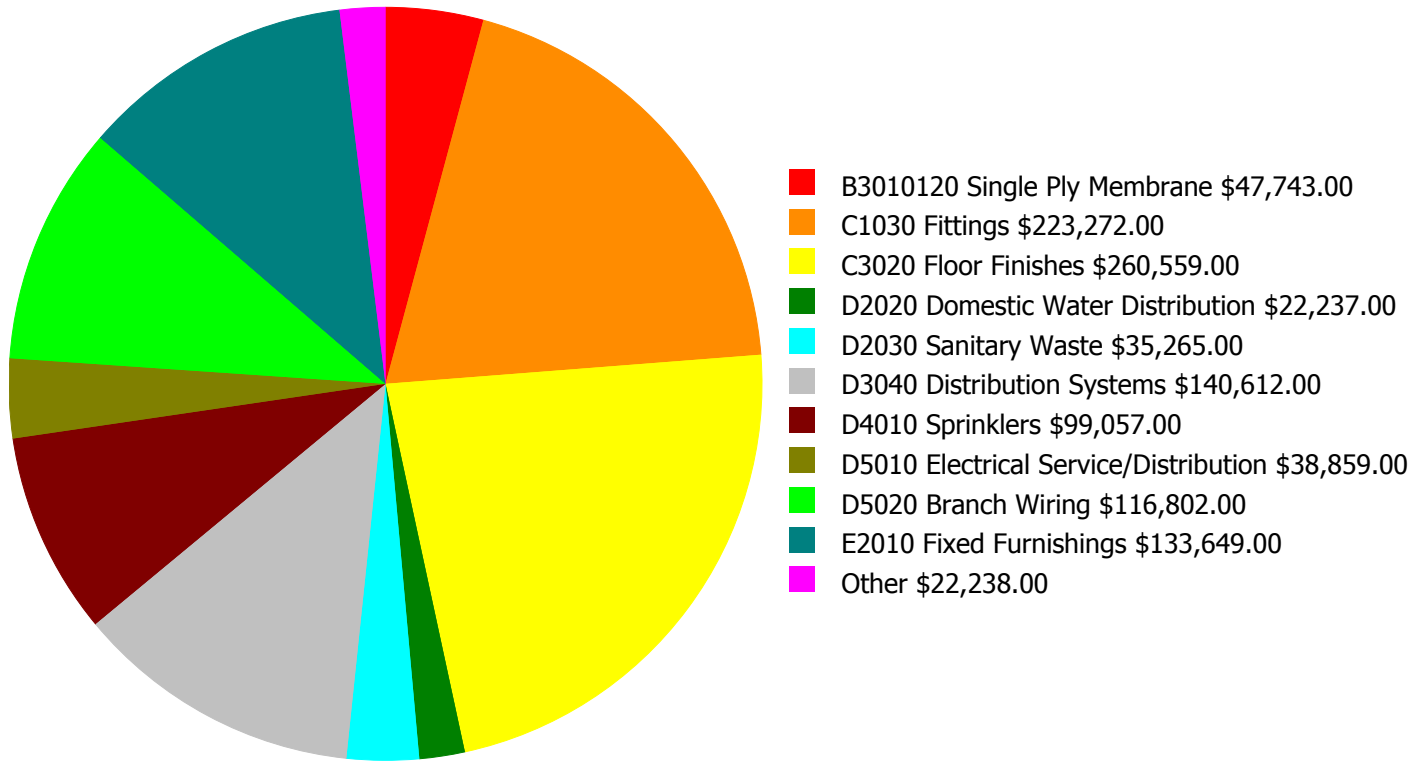
### Deficiency Summary by System

Current deficiencies included assemblies that have reached or exceeded their design life or components of the assemblies that are in need of repair. Assemblies that have reached their design life are identified as current deficiencies and assigned the distress 'Beyond Useful Life'. The following chart lists all current deficiencies associated with this facility.

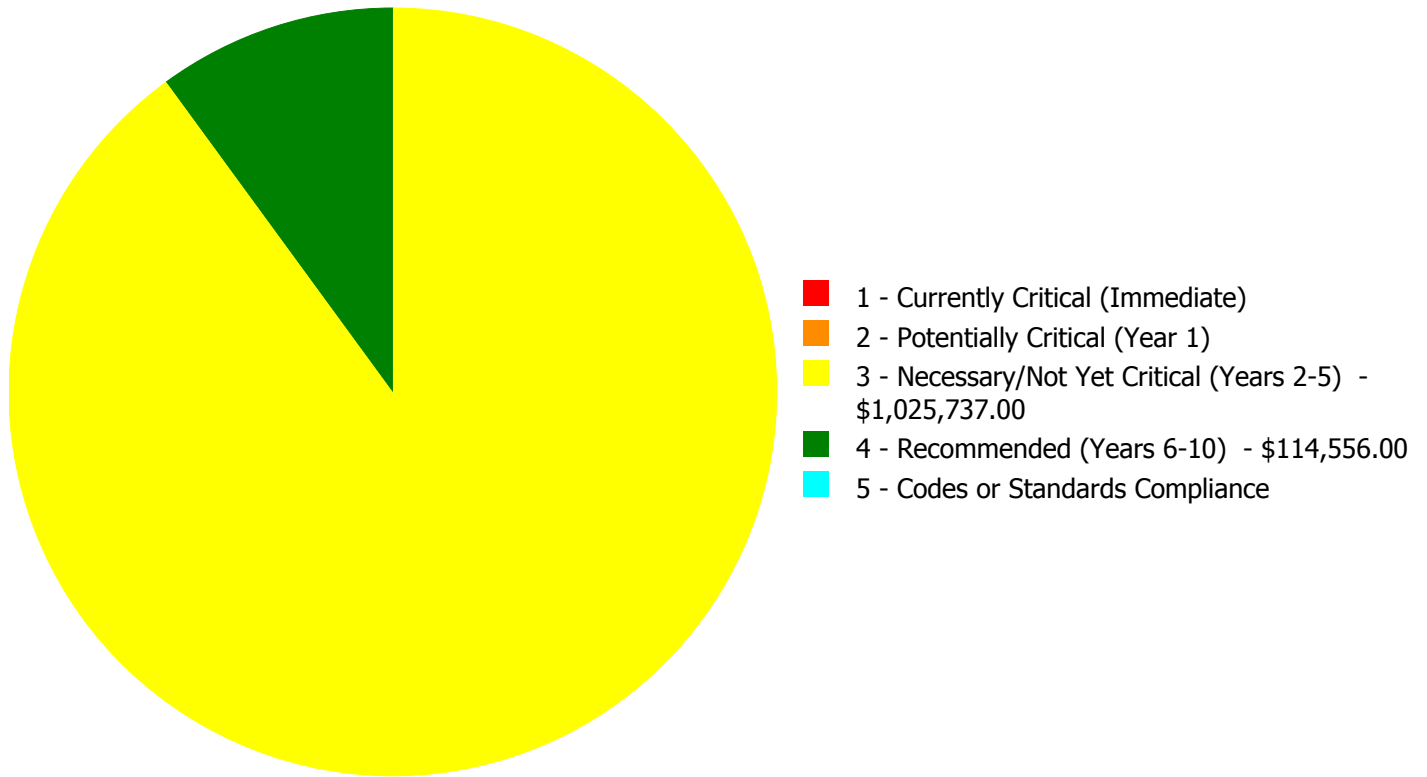
## Deficiency Summary by Priority

The following chart shows the total repair costs broken down by priority. Assessors assigned deficiencies within eCOMET to one of the following priority categories:

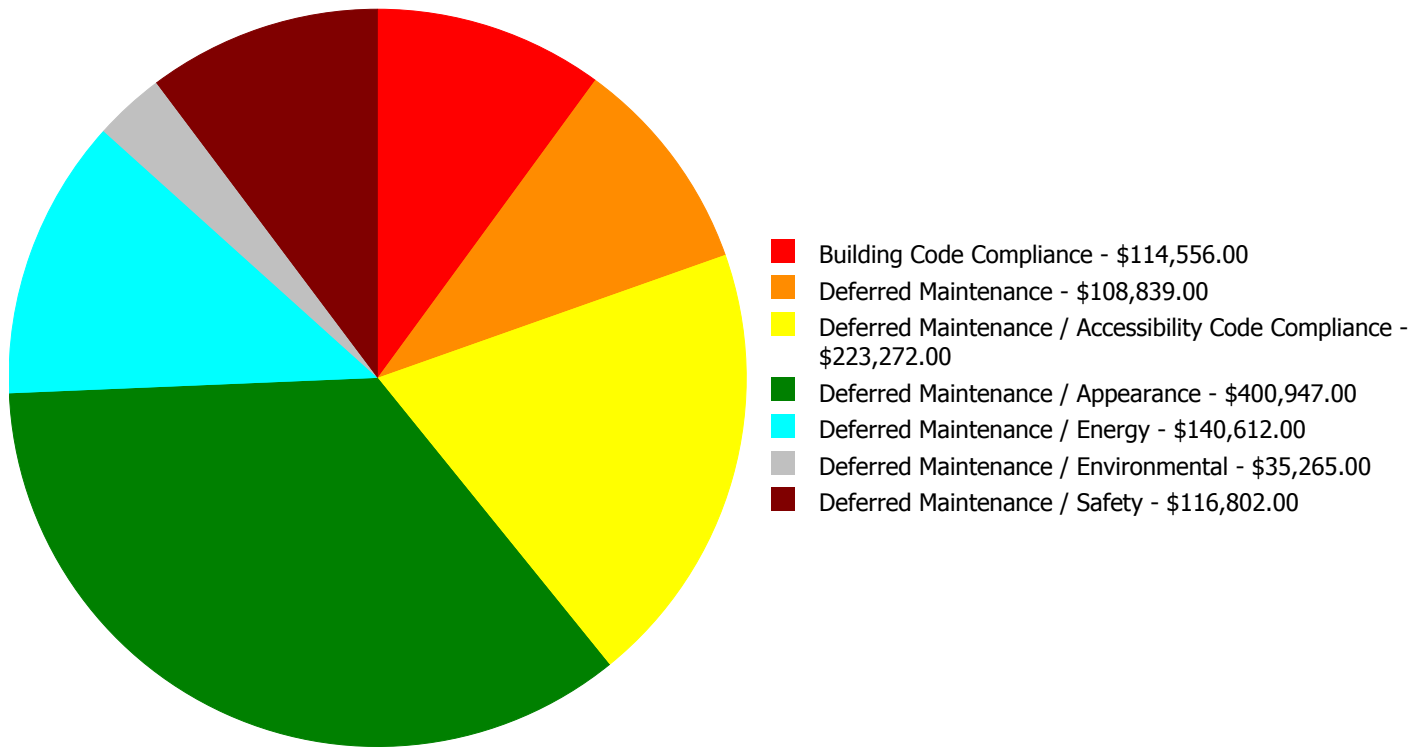
## Deficiency Summary by Category

The following chart shows the total repair costs broken down by deficiency categories. Assessors assigned deficiencies to one of the following categories:

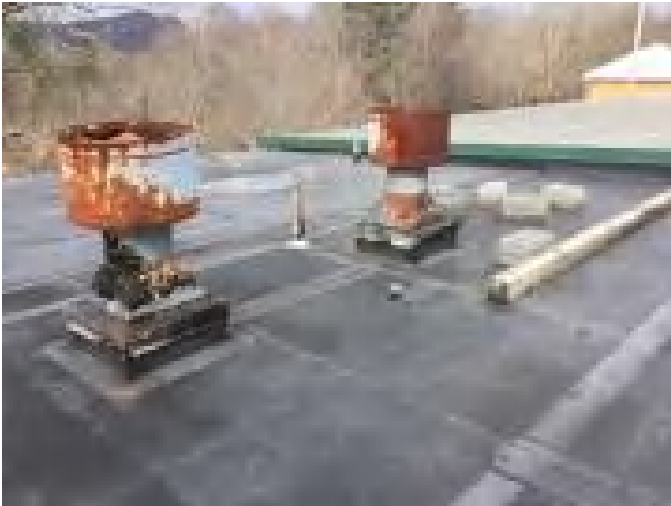
#### System: B3010120 - Single Ply Membrane

**Location:** Cafeteria  
**Distress:** Failing  
**Category:** Deferred Maintenance  
**Priority:** 3 - Necessary/Not Yet Critical (Years 2-5)  
**Correction:** Renew System  
**Qty:** 4,560.00  
**Unit of Measure:** S.F.  
**Estimate:** \$47,743.00  
**Assessor Name:** Terence Davis  
**Date Created:** 01/30/2017

**Notes:** The EPDM adhered roof coverings are aging, showing signs of failure and should be replaced.

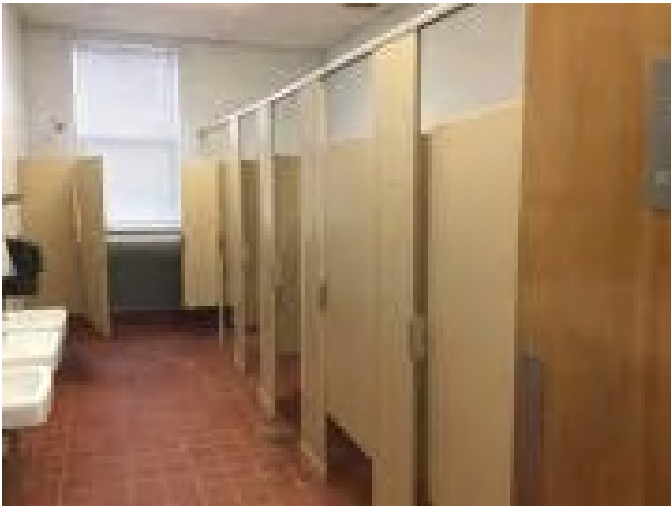
#### System: C1030 - Fittings

**Location:** Throughout  
**Distress:** Beyond Service Life  
**Category:** Deferred Maintenance / Accessibility Code Compliance  
**Priority:** 3 - Necessary/Not Yet Critical (Years 2-5)  
**Correction:** Renew System  
**Qty:** 20,420.00  
**Unit of Measure:** S.F.  
**Estimate:** \$223,272.00  
**Assessor Name:** Terence Davis  
**Date Created:** 01/30/2017

**Notes:** The fittings throughout the building are aged, in marginal condition, handrails and room signage are ADA non-compliance and system should be replaced.
