NC School District/995 Yancey County/High School

# Mountain Heritage High

## Campus Assessment Report

March 7, 2017

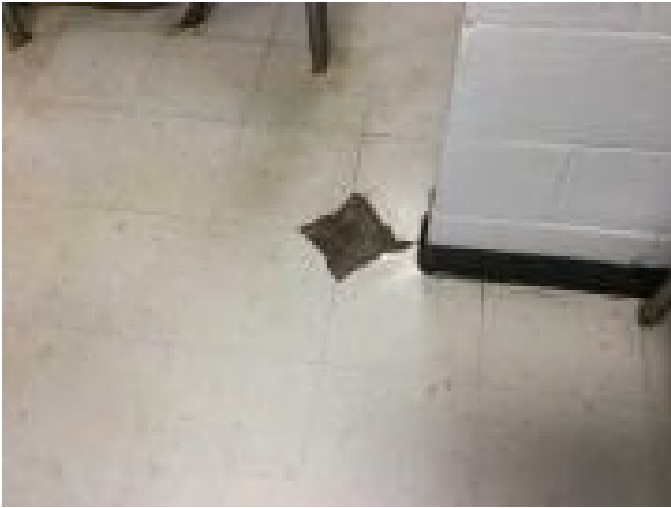
**System: C3020 - Floor Finishes**

**Location:** Throughout  
**Distress:** Beyond Service Life  
**Category:** Deferred Maintenance / Appearance  
**Priority:** 3 - Necessary/Not Yet Critical (Years 2-5)  
**Correction:** Renew System  
**Qty:** 20,420.00  
**Unit of Measure:** S.F.  
**Estimate:** \$260,559.00  
**Assessor Name:** Terence Davis  
**Date Created:** 01/30/2017

**Notes:** The original flooring is in poor conditions, with different areas bubbling or separating from the substrate, and should be replaced.  
The quarry tile in the kitchen spaces is aged, chipped, cracked, patched, worn and should be replaced.  
The VCT flooring is aged, cracked, worn, and should be replaced. Some ACM remains.

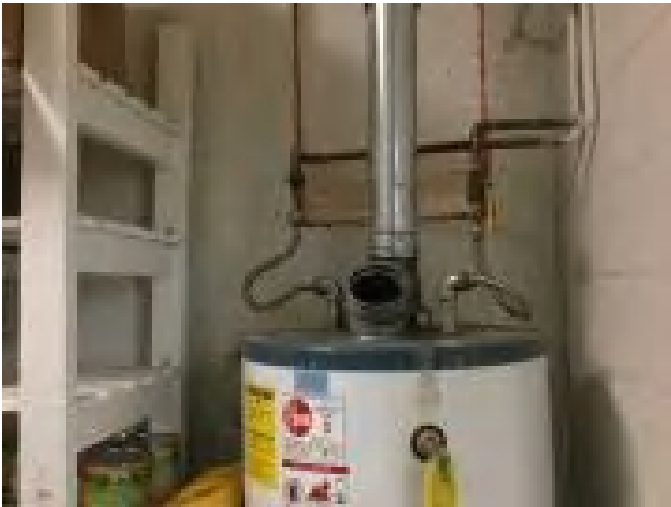
**System: D2020 - Domestic Water Distribution**

**Location:** Throughout  
**Distress:** Beyond Service Life  
**Category:** Deferred Maintenance  
**Priority:** 3 - Necessary/Not Yet Critical (Years 2-5)  
**Correction:** Renew System  
**Qty:** 20,420.00  
**Unit of Measure:** S.F.  
**Estimate:** \$22,237.00  
**Assessor Name:** Terence Davis  
**Date Created:** 01/30/2017

**Notes:** The domestic water distribution system is aged and should be replaced.

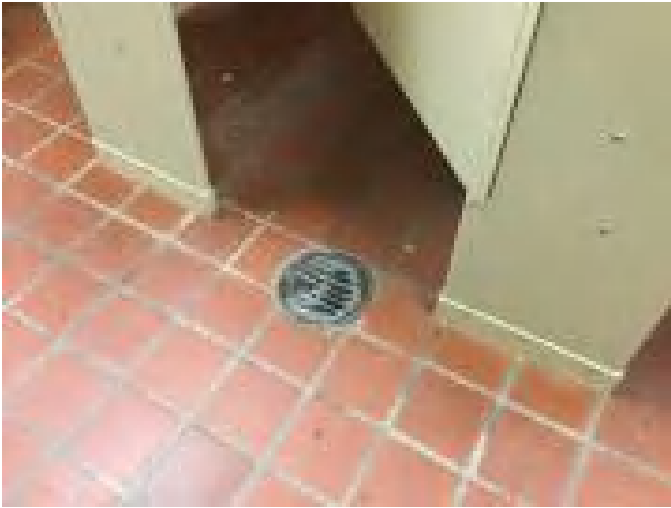
**System: D2030 - Sanitary Waste**

**Location:** Throughout  
**Distress:** Beyond Service Life  
**Category:** Deferred Maintenance / Environmental  
**Priority:** 3 - Necessary/Not Yet Critical (Years 2-5)  
**Correction:** Renew System  
**Qty:** 20,420.00  
**Unit of Measure:** S.F.  
**Estimate:** \$35,265.00  
**Assessor Name:** Terence Davis  
**Date Created:** 01/30/2017

**Notes:** The sanitary waste system is aged, has reported periodic failures, and should be replaced.

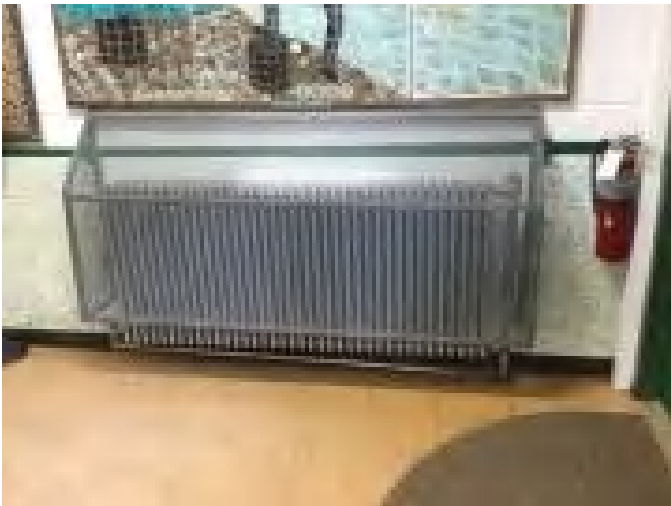
**System: D3040 - Distribution Systems**

**Location:** Throughout  
**Distress:** Beyond Service Life  
**Category:** Deferred Maintenance / Energy  
**Priority:** 3 - Necessary/Not Yet Critical (Years 2-5)  
**Correction:** Renew System  
**Qty:** 20,420.00  
**Unit of Measure:** S.F.  
**Estimate:** \$140,612.00  
**Assessor Name:** Terence Davis  
**Date Created:** 01/30/2017

**Notes:** The steam and hot water supply distribution system is aged, in marginal condition, and should be replaced.

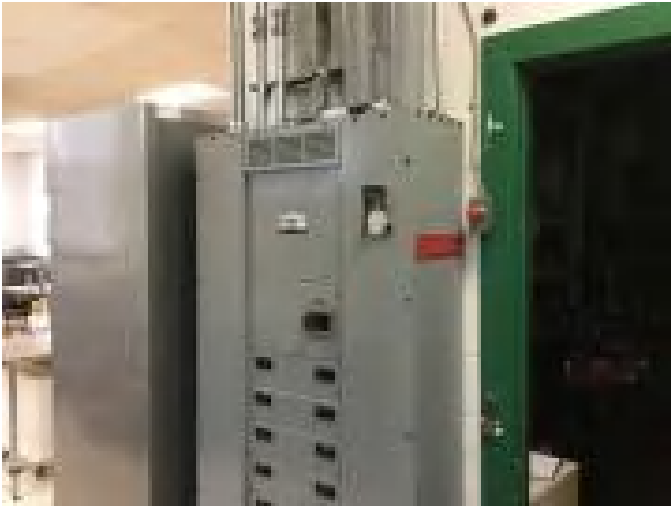
**System: D5010 - Electrical Service/Distribution**

**Location:** Throughout  
**Distress:** Beyond Service Life  
**Category:** Deferred Maintenance  
**Priority:** 3 - Necessary/Not Yet Critical (Years 2-5)  
**Correction:** Renew System  
**Qty:** 20,420.00  
**Unit of Measure:** S.F.  
**Estimate:** \$38,859.00  
**Assessor Name:** Terence Davis  
**Date Created:** 01/30/2017

**Notes:** The original electrical distribution system is operating properly due to an aggressive maintenance program but is aged, in marginal condition, and should be replaced.

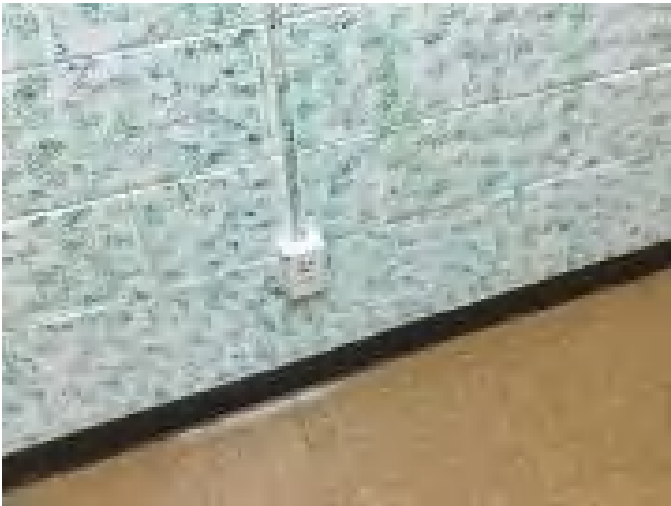
**System: D5020 - Branch Wiring**

**Location:** Throughout  
**Distress:** Beyond Service Life  
**Category:** Deferred Maintenance / Safety  
**Priority:** 3 - Necessary/Not Yet Critical (Years 2-5)  
**Correction:** Renew System  
**Qty:** 20,420.00  
**Unit of Measure:** S.F.  
**Estimate:** \$116,802.00  
**Assessor Name:** Terence Davis  
**Date Created:** 01/30/2017

**Notes:** The original branch wiring system is operating, but is aged, in poor condition, and should be replaced.

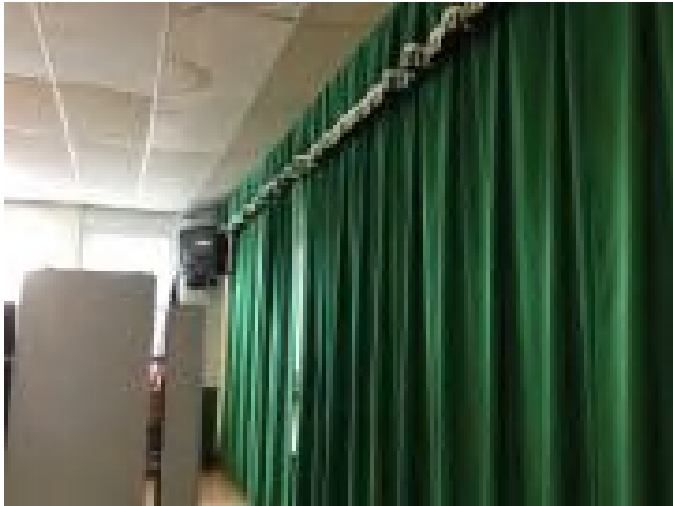
**System: E1020 - Institutional Equipment**

**Location:** Stage  
**Distress:** Beyond Service Life  
**Category:** Deferred Maintenance / Appearance  
**Priority:** 3 - Necessary/Not Yet Critical (Years 2-5)  
**Correction:** Renew System  
**Qty:** 20,420.00  
**Unit of Measure:** S.F.  
**Estimate:** \$6,739.00  
**Assessor Name:** Terence Davis  
**Date Created:** 01/30/2017

**Notes:** Theater equipment is aging and worn and should be replaced.

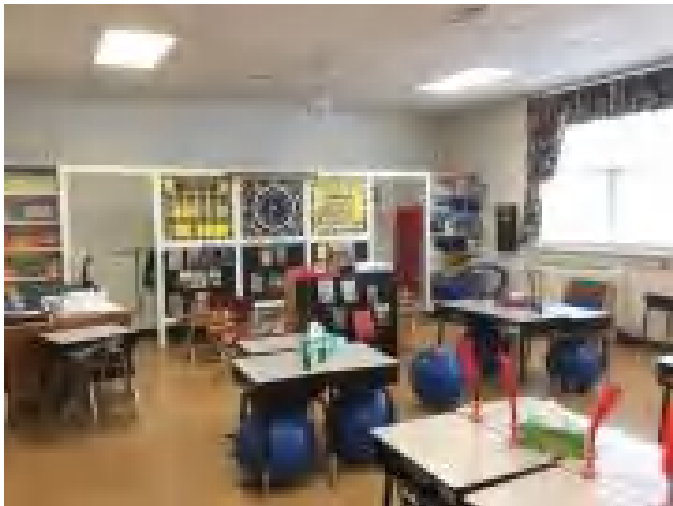
**System: E2010 - Fixed Furnishings**

**Location:** Throughout  
**Distress:** Beyond Service Life  
**Category:** Deferred Maintenance / Appearance  
**Priority:** 3 - Necessary/Not Yet Critical (Years 2-5)  
**Correction:** Renew System  
**Qty:** 20,420.00  
**Unit of Measure:** S.F.  
**Estimate:** \$133,649.00  
**Assessor Name:** Terence Davis  
**Date Created:** 01/30/2017

**Notes:** The fixed furnishings are aged, in marginal condition, and should be replaced.

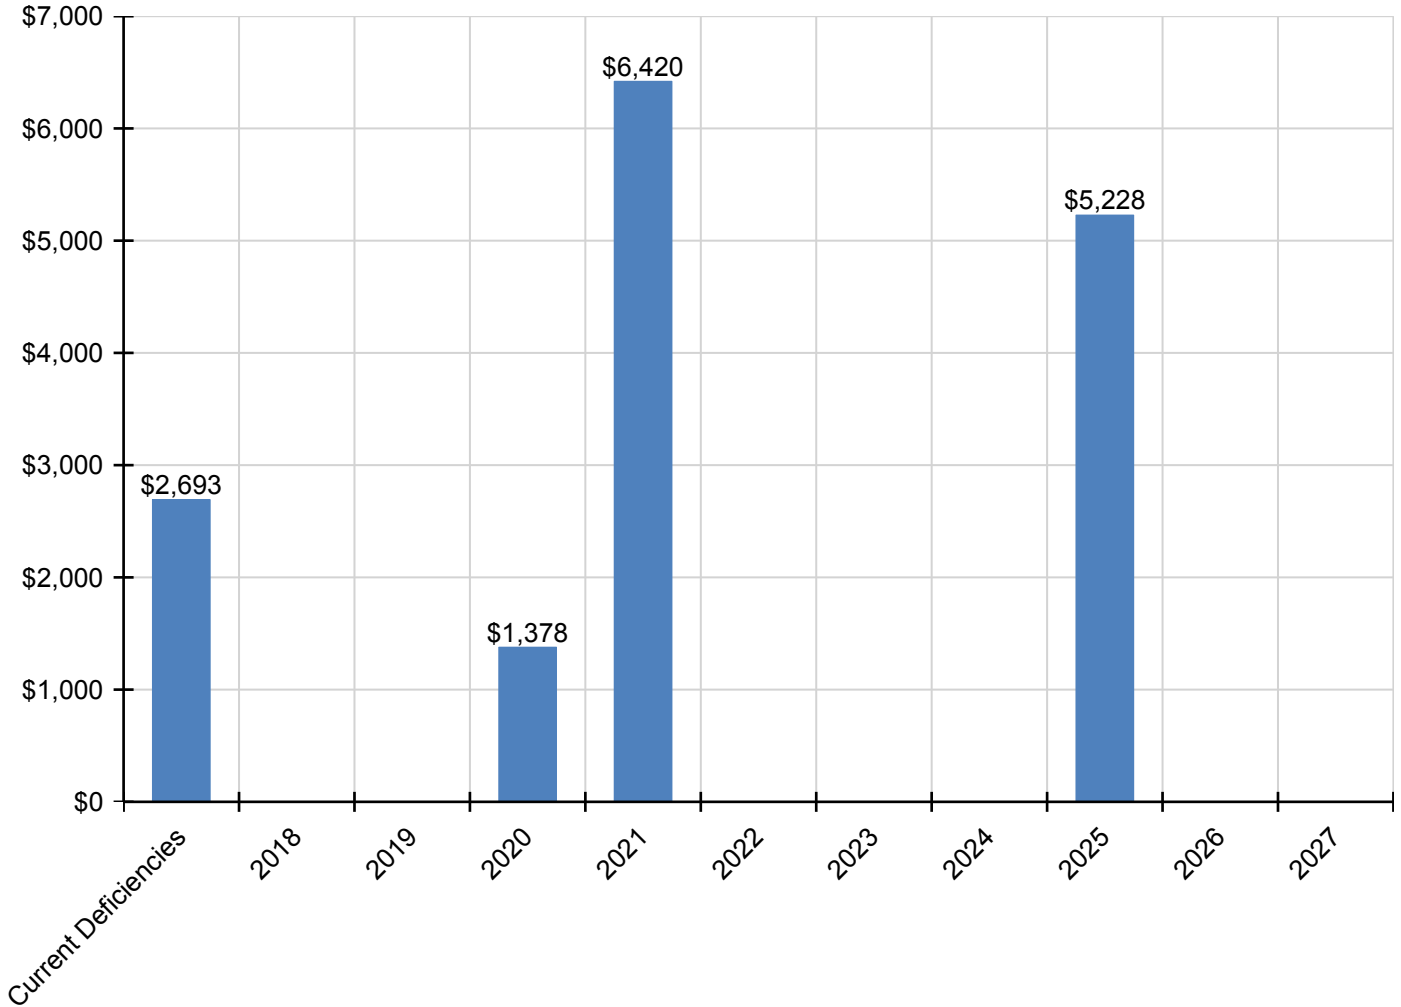
## Forecasted Capital Renewal Requirement

The following chart shows the current building deficiencies and forecasting capital renewal or sustainment requirements over the next ten years.

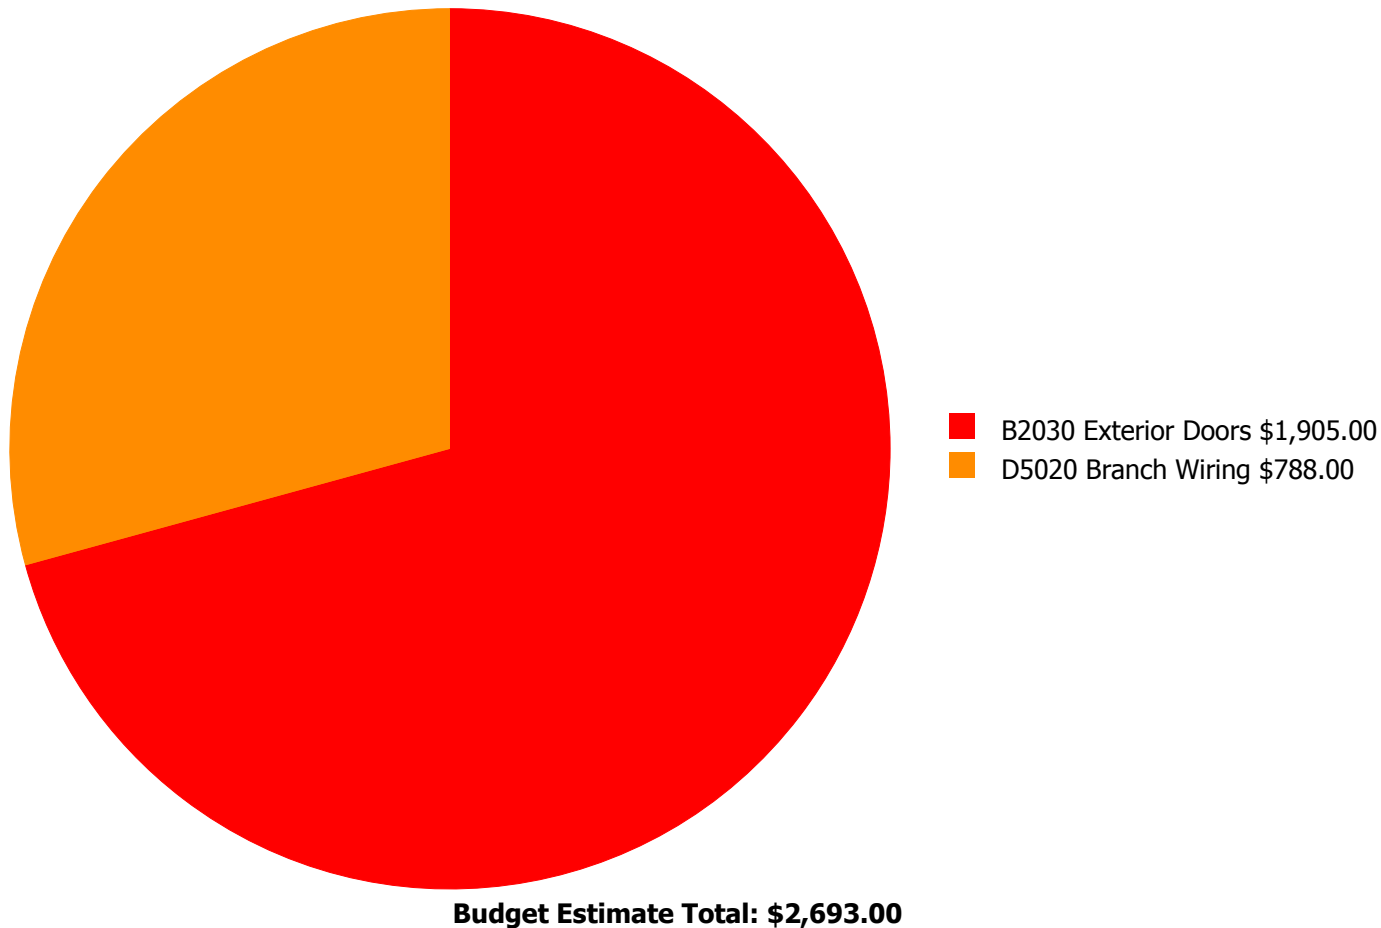
### Deficiency Summary by System

Current deficiencies included assemblies that have reached or exceeded their design life or components of the assemblies that are in need of repair. Assemblies that have reached their design life are identified as current deficiencies and assigned the distress 'Beyond Useful Life'. The following chart lists all current deficiencies associated with this facility.

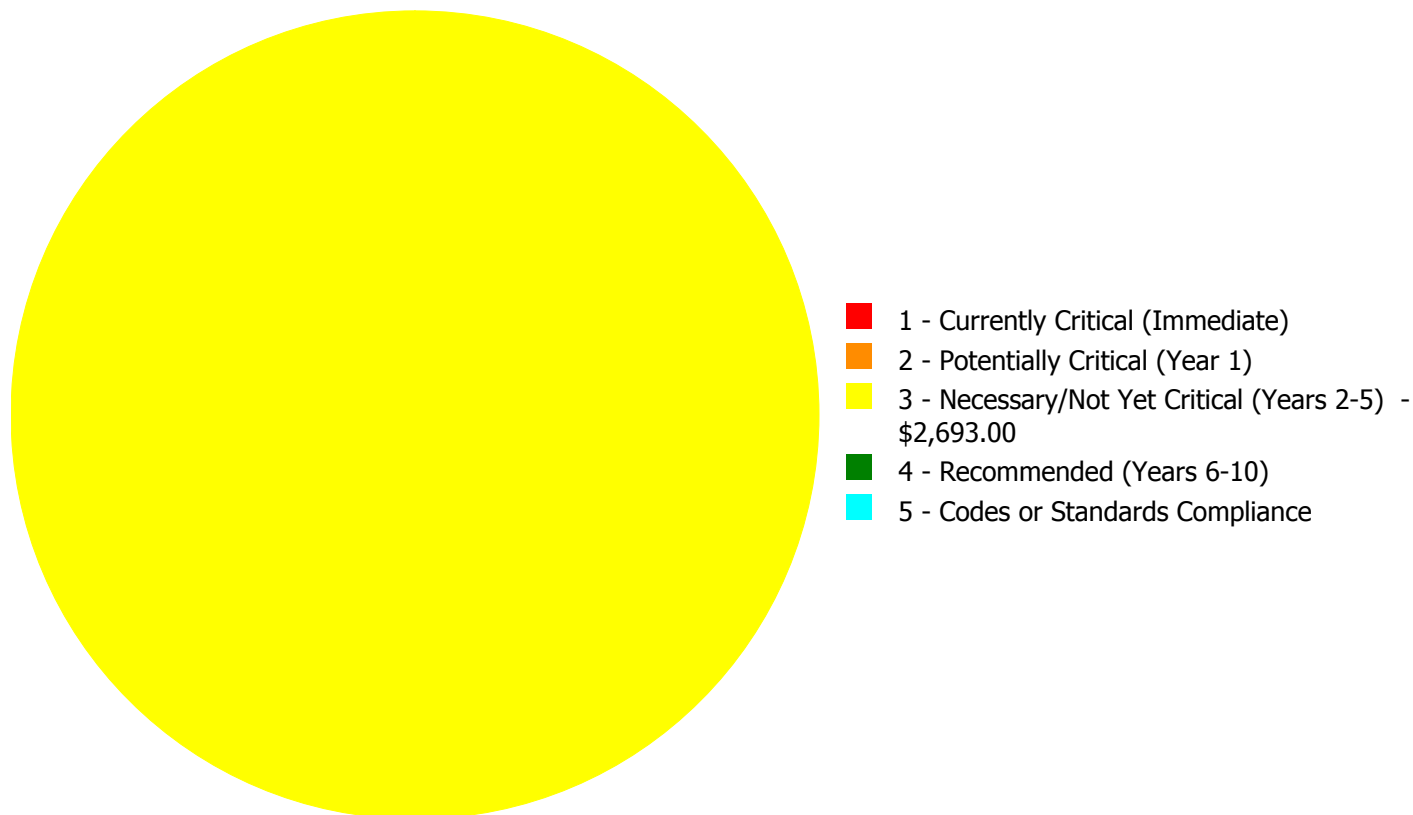
## Deficiency Summary by Priority

The following chart shows the total repair costs broken down by priority. Assessors assigned deficiencies within eCOMET to one of the following priority categories:

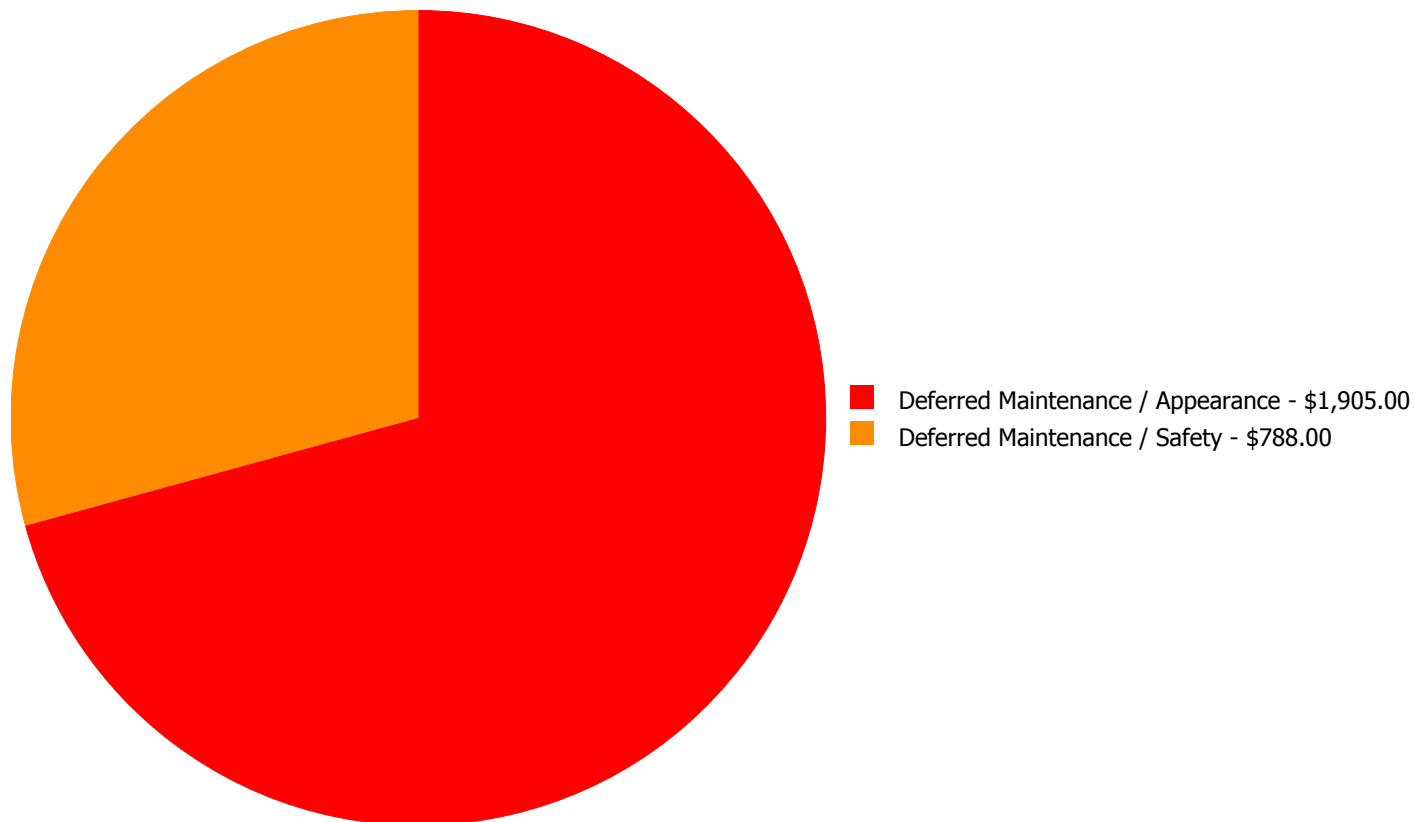
### Deficiency Summary by Category

The following chart shows the total repair costs broken down by deficiency categories. Assessors assigned deficiencies to one of the following categories:

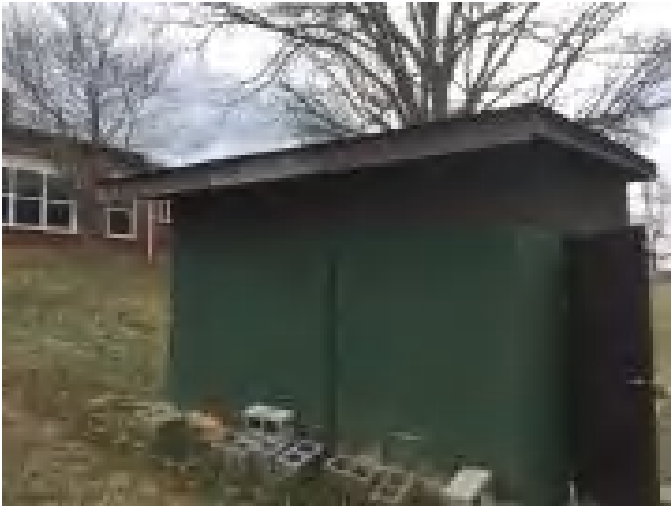
#### System: B2030 - Exterior Doors

**Location:** Entry  
**Distress:** Beyond Service Life  
**Category:** Deferred Maintenance / Appearance  
**Priority:** 3 - Necessary/Not Yet Critical (Years 2-5)  
**Correction:** Renew System  
**Qty:** 200.00  
**Unit of Measure:** S.F.  
**Estimate:** \$1,905.00  
**Assessor Name:** Terence Davis  
**Date Created:** 01/30/2017

**Notes:** The original exterior doors are aged, rusted, and should be replaced.

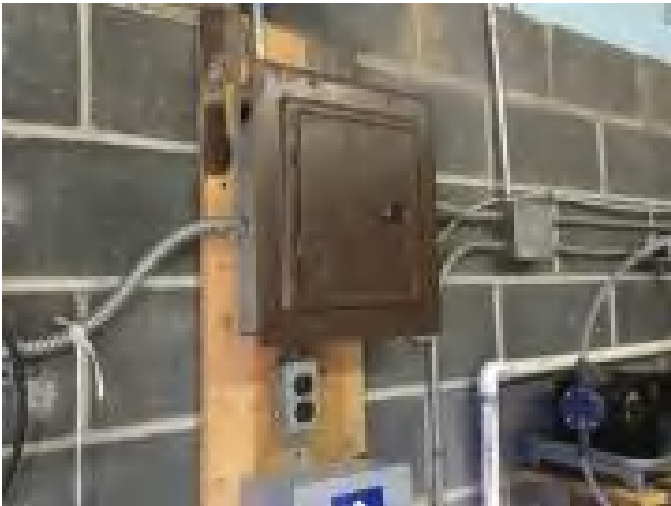
#### System: D5020 - Branch Wiring

**Location:** Throughout  
**Distress:** Beyond Service Life  
**Category:** Deferred Maintenance / Safety  
**Priority:** 3 - Necessary/Not Yet Critical (Years 2-5)  
**Correction:** Renew System  
**Qty:** 200.00  
**Unit of Measure:** S.F.  
**Estimate:** \$788.00  
**Assessor Name:** Terence Davis  
**Date Created:** 01/30/2017

**Notes:** The original branch wiring system is operating, but is aged, in poor condition, and should be replaced.

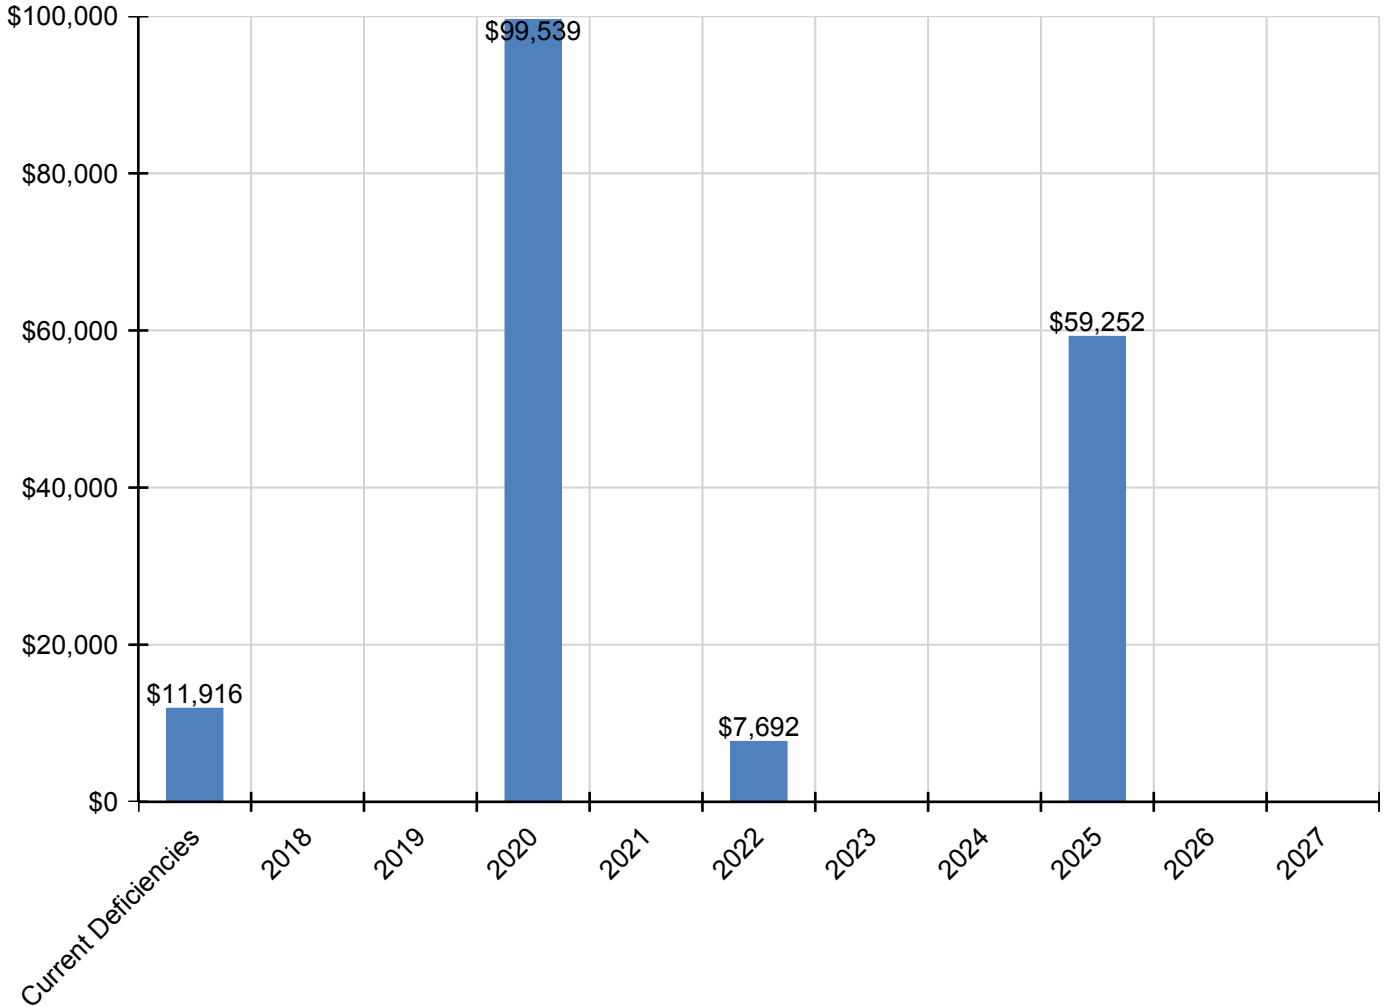
## Forecasted Capital Renewal Requirement

The following chart shows the current building deficiencies and forecasting capital renewal or sustainment requirements over the next ten years.

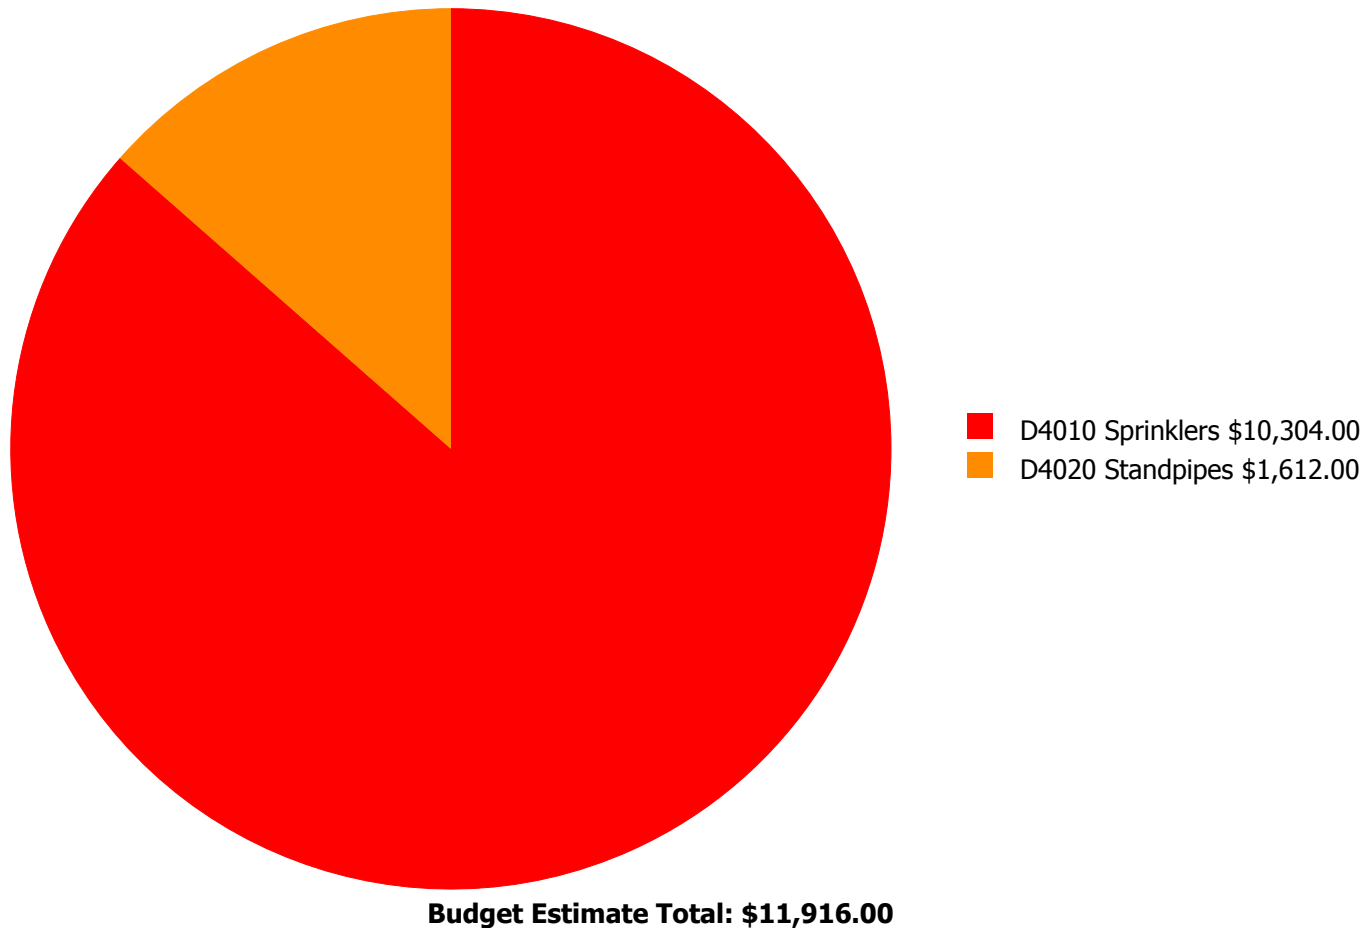
### Deficiency Summary by System

Current deficiencies included assemblies that have reached or exceeded their design life or components of the assemblies that are in need of repair. Assemblies that have reached their design life are identified as current deficiencies and assigned the distress 'Beyond Useful Life'. The following chart lists all current deficiencies associated with this facility.

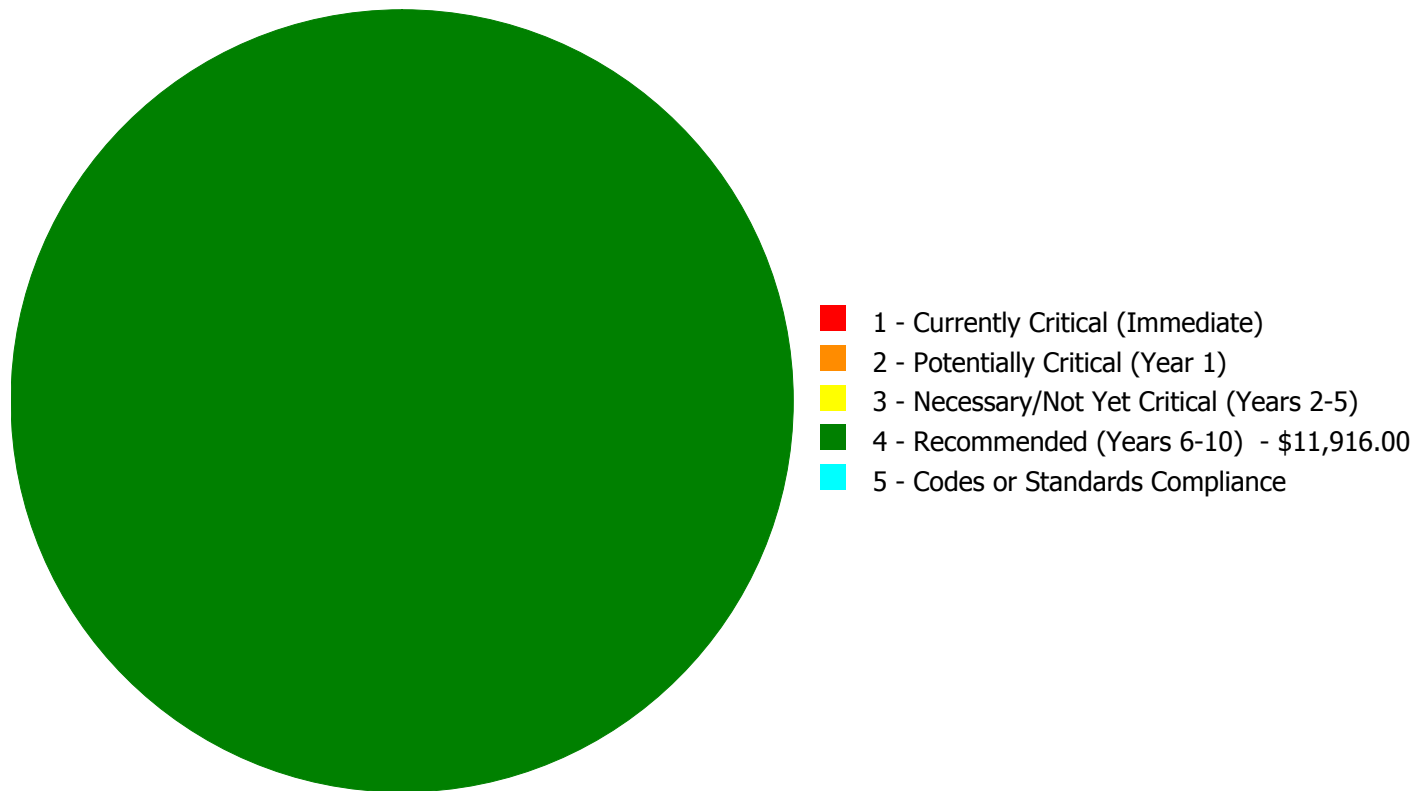
## Deficiency Summary by Priority

The following chart shows the total repair costs broken down by priority. Assessors assigned deficiencies within eCOMET to one of the following priority categories:

**Budget Estimate Total: \$11,916.00**

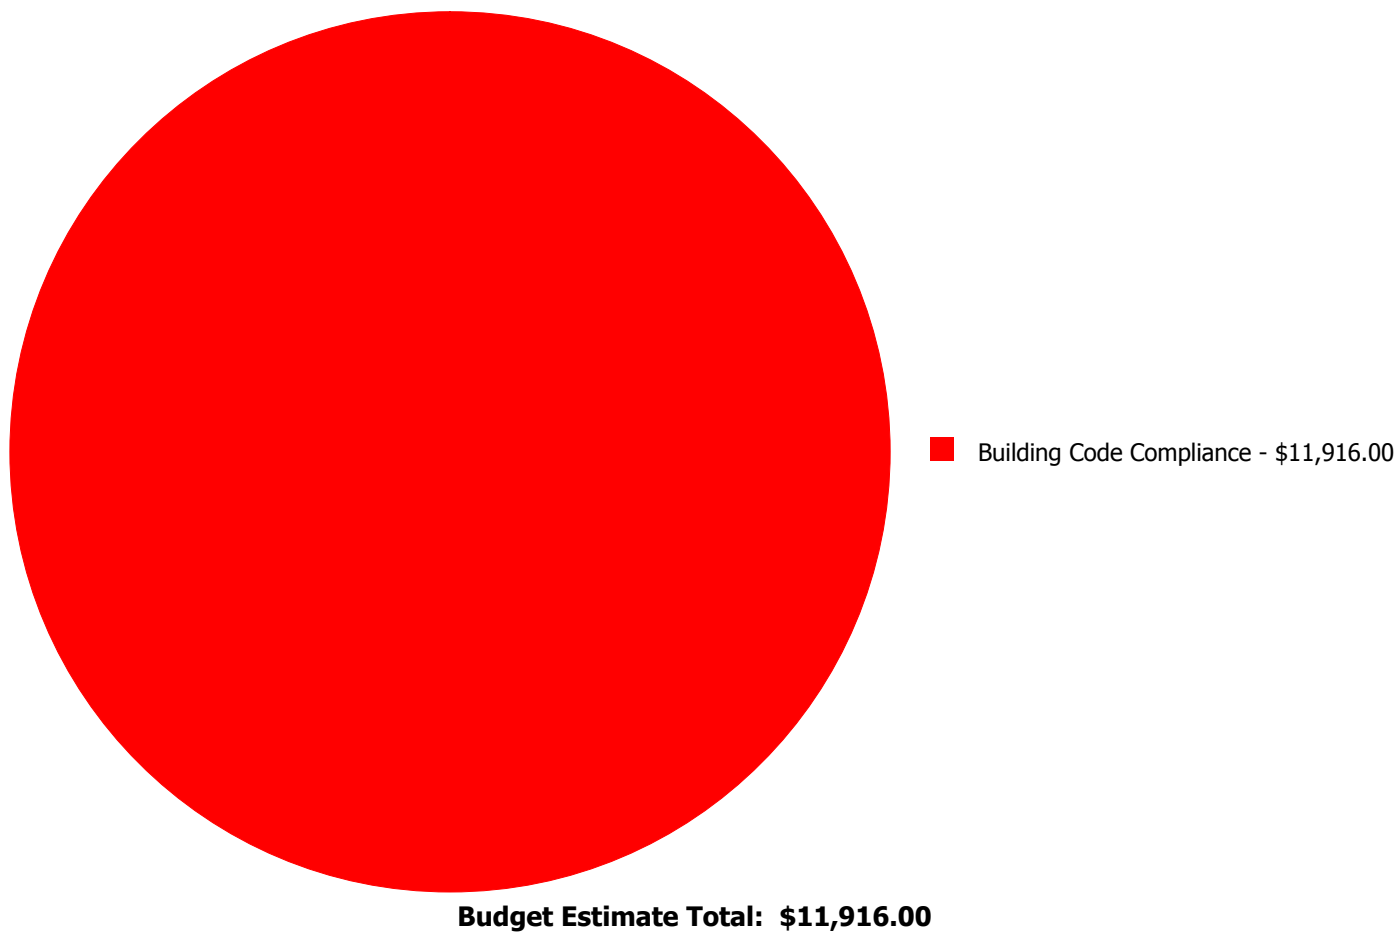
## Deficiency Summary by Category

The following chart shows the total repair costs broken down by deficiency categories. Assessors assigned deficiencies to one of the following categories:

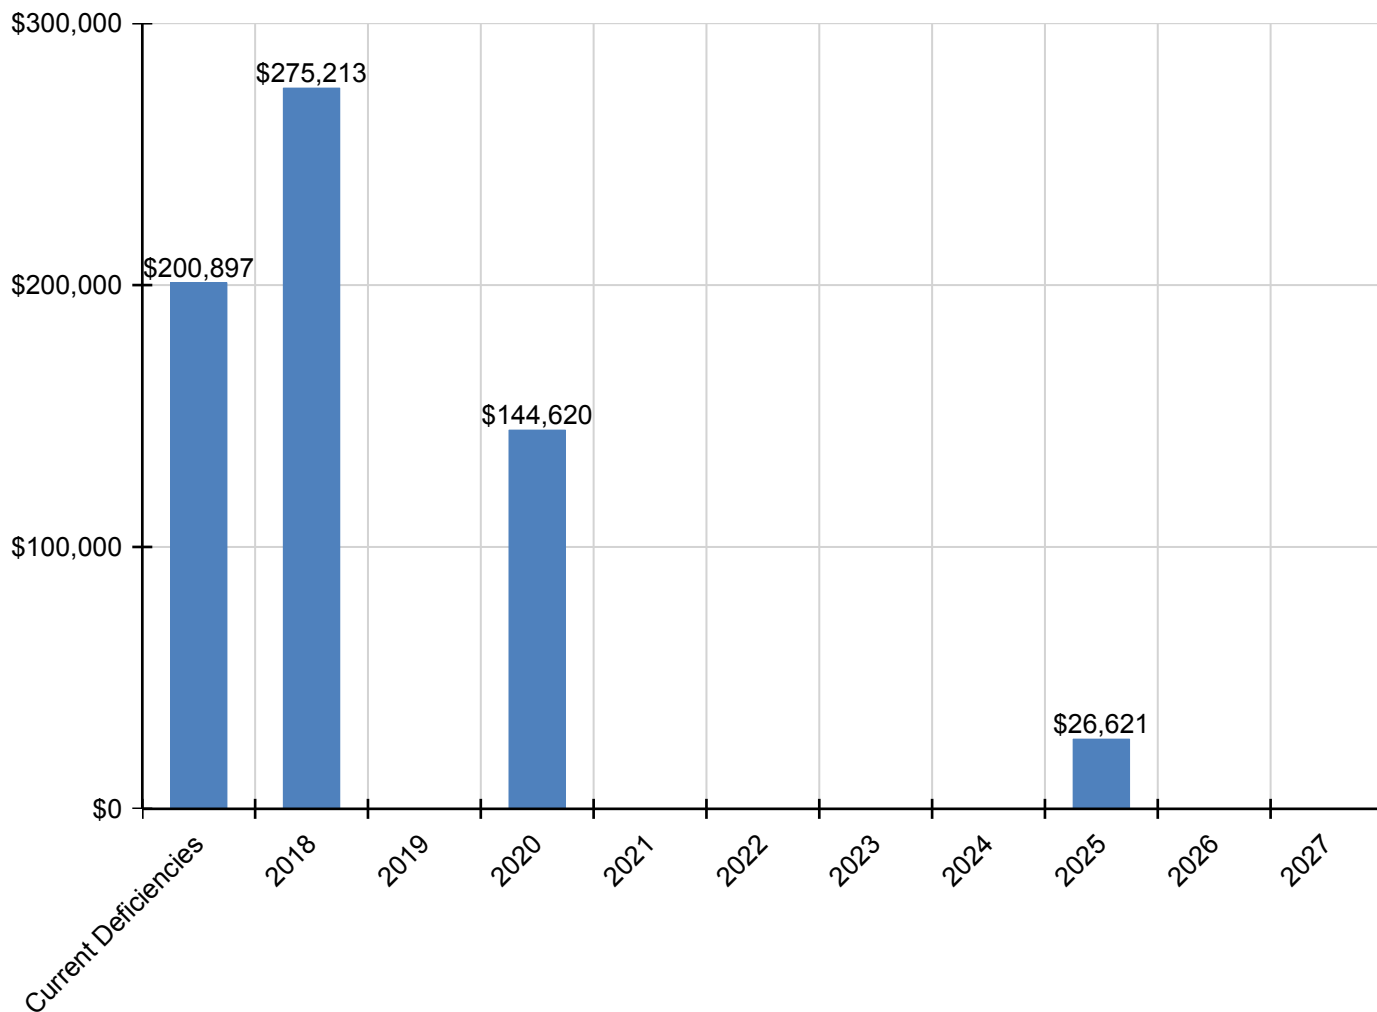
## Forecasted Capital Renewal Requirement

The following chart shows the current building deficiencies and forecasting capital renewal or sustainment requirements over the next ten years.

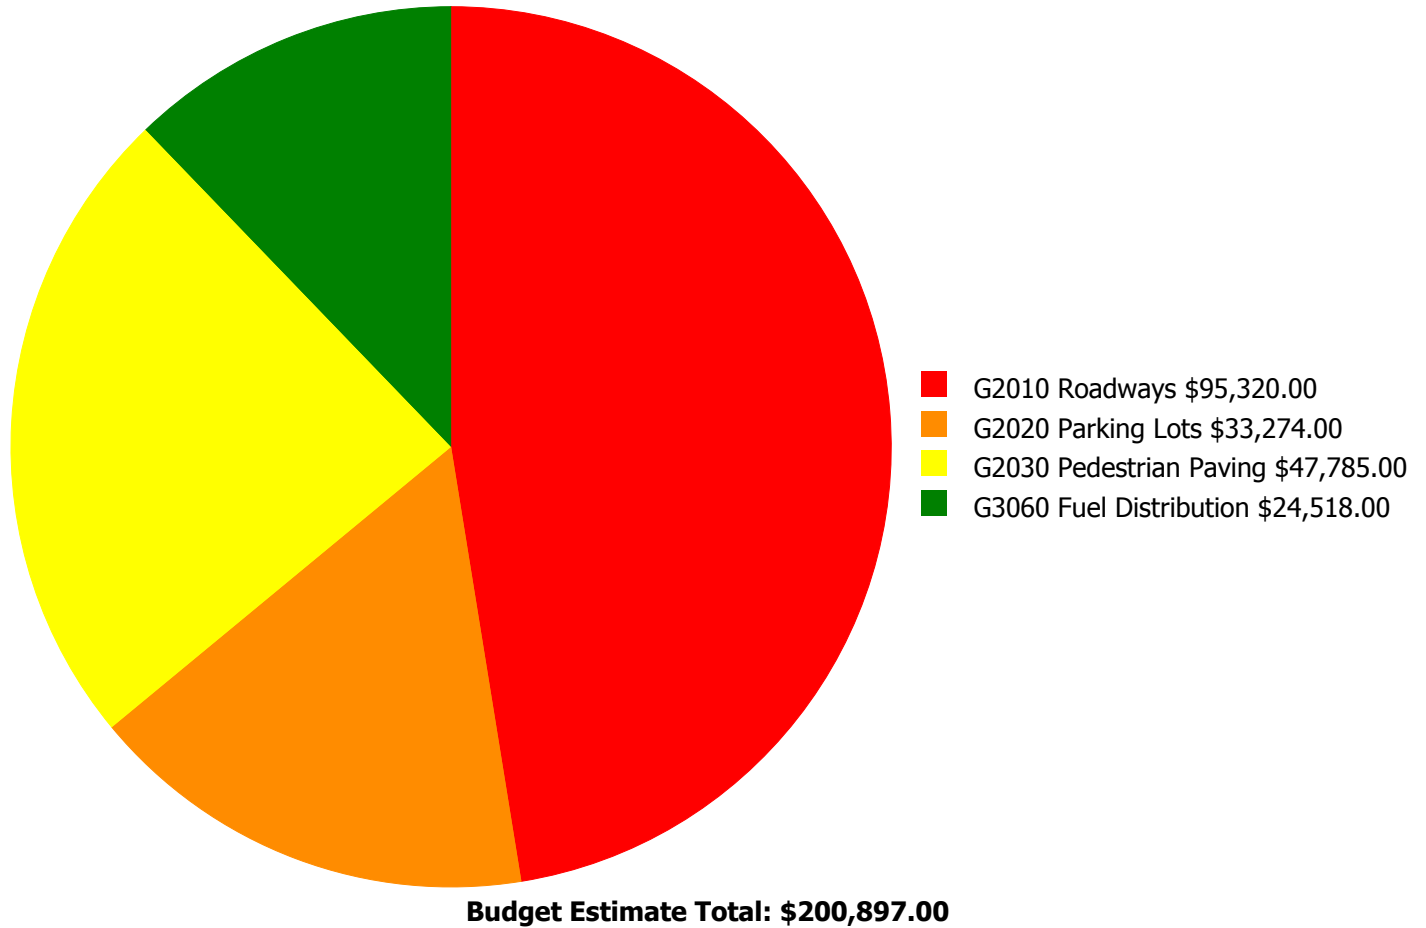
## Deficiency Summary by System

Current deficiencies included assemblies that have reached or exceeded their design life or components of the assemblies that are in need of repair. Assemblies that have reached their design life are identified as current deficiencies and assigned the distress 'Beyond Useful Life'. The following chart lists all current deficiencies associated with this facility.

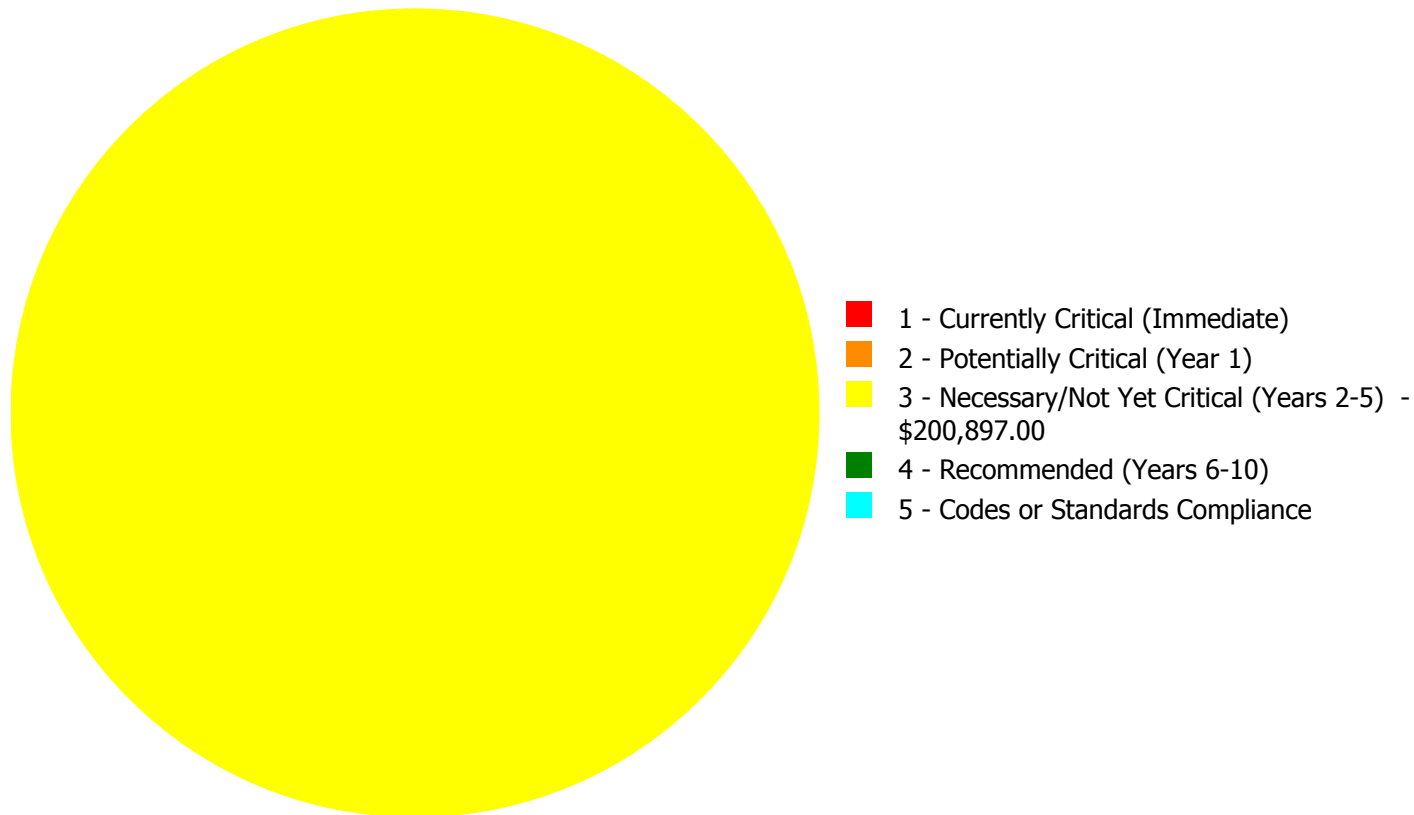
## Deficiency Summary by Priority

The following chart shows the total repair costs broken down by priority. Assessors assigned deficiencies within eCOMET to one of the following priority categories:

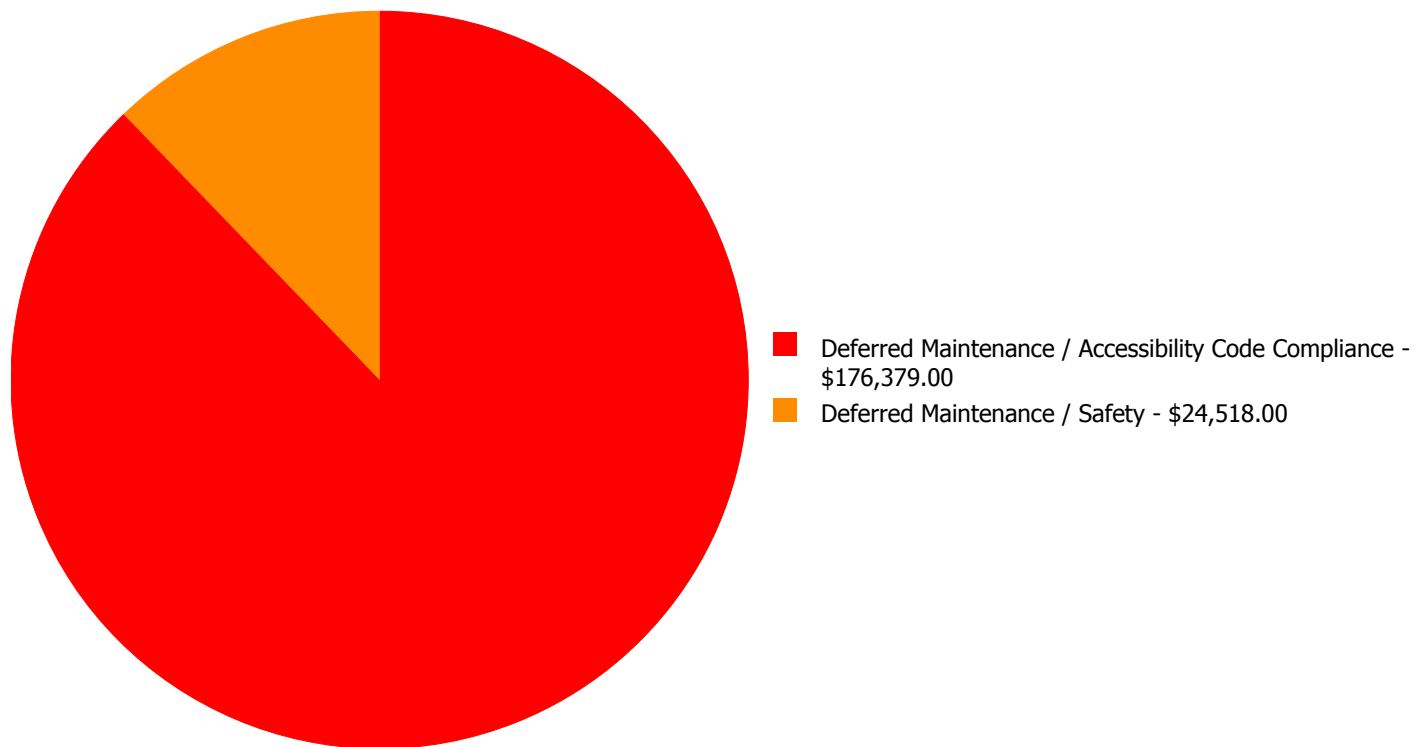
## Deficiency Summary by Category

The following chart shows the total repair costs broken down by deficiency categories. Assessors assigned deficiencies to one of the following categories:

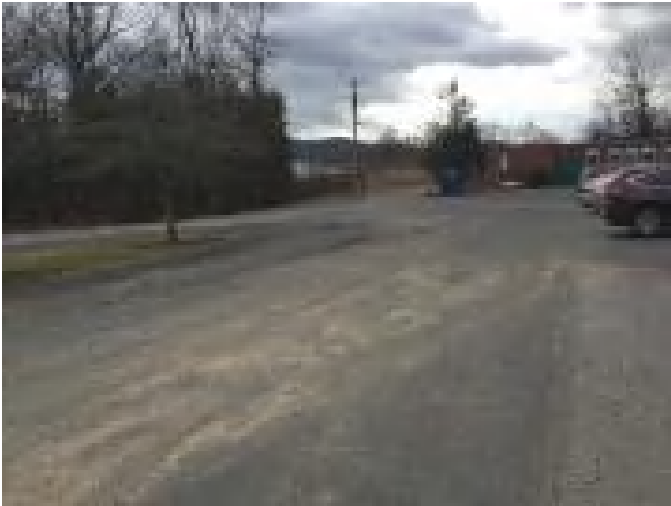
#### System: G2010 - Roadways

**Location:** Throughout  
**Distress:** Failing  
**Category:** Deferred Maintenance / Accessibility Code Compliance  
**Priority:** 3 - Necessary/Not Yet Critical (Years 2-5)  
**Correction:** Renew System  
**Qty:** 22,744.00  
**Unit of Measure:** S.F.  
**Estimate:** \$95,320.00  
**Assessor Name:** Eduardo Lopez  
**Date Created:** 01/30/2017

**Notes:** The asphaltic roadway is aged, has many road cuts, cracks, potholes and repairs, and should be replaced.

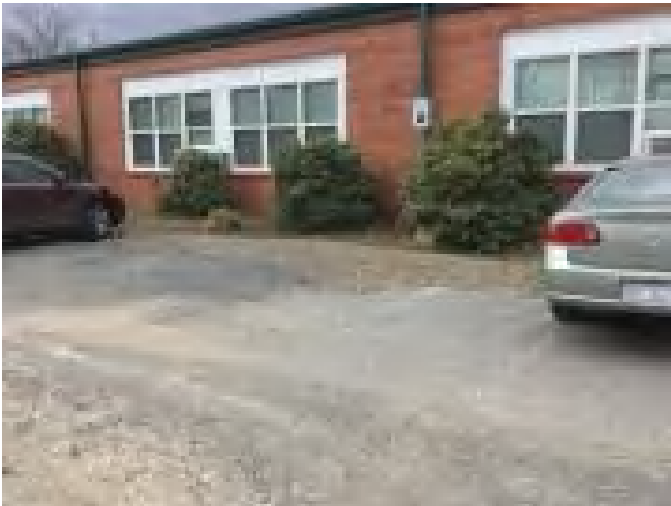
#### System: G2020 - Parking Lots

**Location:** Throughout  
**Distress:** Failing  
**Category:** Deferred Maintenance / Accessibility Code Compliance  
**Priority:** 3 - Necessary/Not Yet Critical (Years 2-5)  
**Correction:** Renew System  
**Qty:** 22,744.00  
**Unit of Measure:** S.F.  
**Estimate:** \$33,274.00  
**Assessor Name:** Eduardo Lopez  
**Date Created:** 01/30/2017

**Notes:** The parking lot is aged, has many repairs and potholes, and should be replaced and re-stripped. ADA signs height needs to be adjusted per minimum ADA standards.

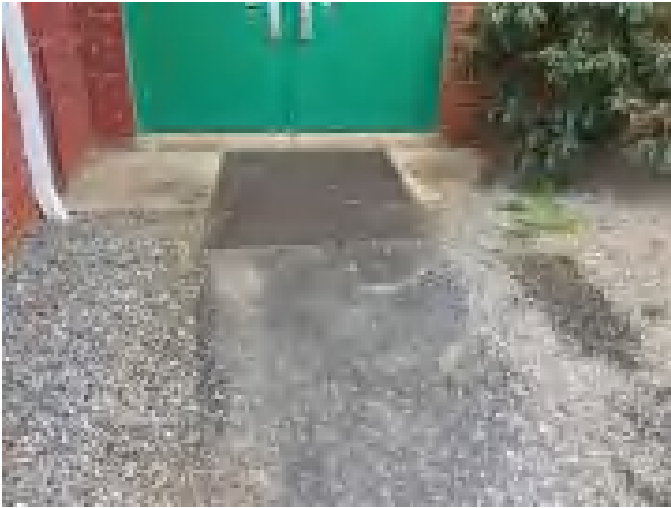
**System: G2030 - Pedestrian Paving**

**Location:** Throughout  
**Distress:** Beyond Service Life  
**Category:** Deferred Maintenance / Accessibility Code Compliance  
**Priority:** 3 - Necessary/Not Yet Critical (Years 2-5)  
**Correction:** Renew System  
**Qty:** 22,744.00  
**Unit of Measure:** S.F.  
**Estimate:** \$47,785.00  
**Assessor Name:** Eduardo Lopez  
**Date Created:** 01/30/2017

**Notes:** The pedestrian paving and walkways are aged and showing inclement weather damage and should be replaced to include missing ramps per ADA standards.

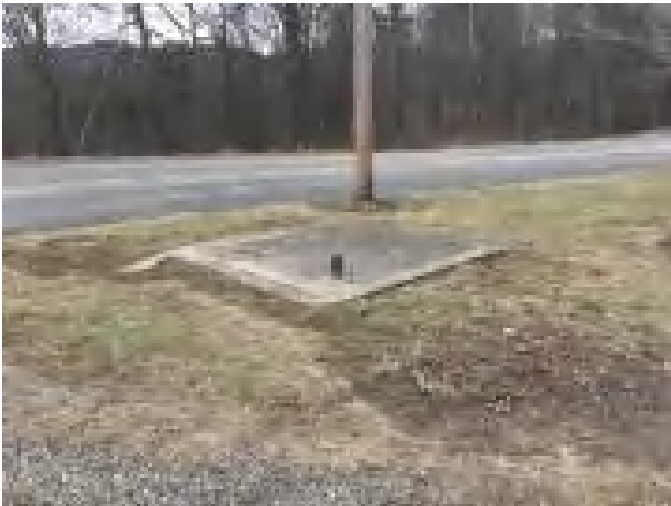
**System: G3060 - Fuel Distribution**

**Location:** Boiler Exterior  
**Distress:** Failing  
**Category:** Deferred Maintenance / Safety  
**Priority:** 3 - Necessary/Not Yet Critical (Years 2-5)  
**Correction:** Renew System  
**Qty:** 22,744.00  
**Unit of Measure:** S.F.  
**Estimate:** \$24,518.00  
**Assessor Name:** Eduardo Lopez  
**Date Created:** 01/30/2017

**Notes:** The fuel distribution system is aged, becoming logistically unsupportable, and should be replaced.
