# Anson Middle

## Campus Assessment Report

March 7, 2017

## Campus Assessment Report - 1966 Building, Cafe/Gym

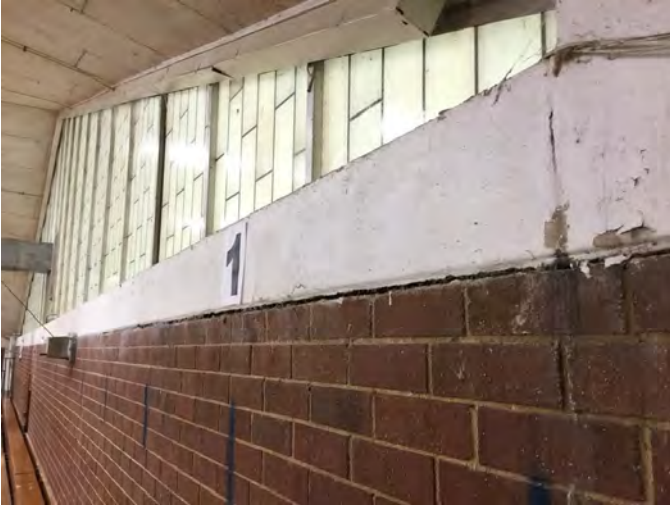
#### System: B2020 - Exterior Windows

**Location:** Exterior Walls  
**Distress:** Beyond Service Life  
**Category:** Deferred Maintenance  
**Priority:** 3 - Necessary/Not Yet Critical (Years 2-5)  
**Correction:** Renew System  
**Qty:** 28,376.00  
**Unit of Measure:** S.F.  
**Estimate:** \$363,326.00  
**Assessor Name:** Eduardo Lopez  
**Date Created:** 01/11/2017

**Notes:** The exterior windows are aged, rusted, not energy efficient and should be replaced.

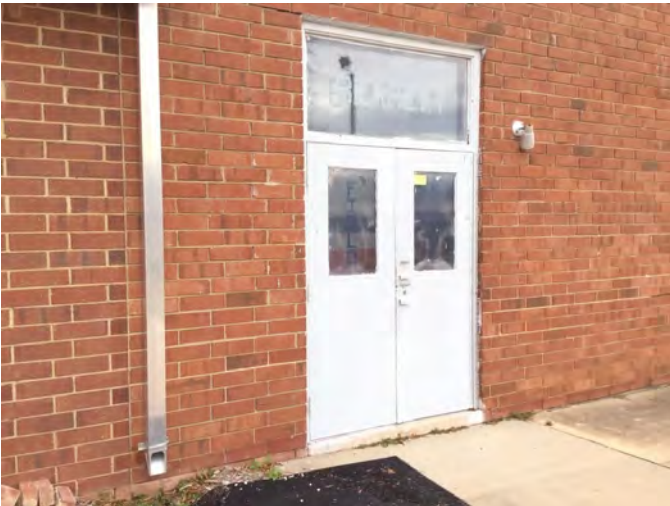
#### System: B2030 - Exterior Doors

**Location:** Exterior Walls  
**Distress:** Beyond Service Life  
**Category:** Deferred Maintenance  
**Priority:** 3 - Necessary/Not Yet Critical (Years 2-5)  
**Correction:** Renew System  
**Qty:** 28,376.00  
**Unit of Measure:** S.F.  
**Estimate:** \$35,584.00  
**Assessor Name:** Eduardo Lopez  
**Date Created:** 01/11/2017

**Notes:** The exterior doors are aged, rusted and should be replaced.

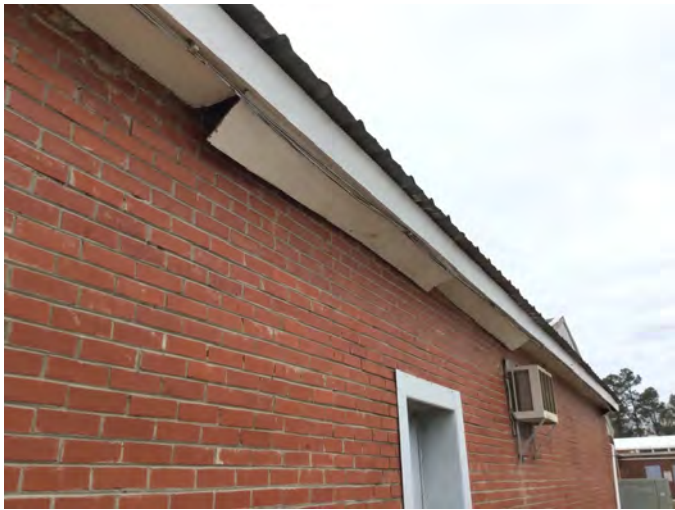
**System: B3010130 - Preformed Metal Roofing**

**Location:** Roof  
**Distress:** Beyond Service Life  
**Category:** Deferred Maintenance  
**Priority:** 3 - Necessary/Not Yet Critical (Years 2-5)  
**Correction:** Renew System  
**Qty:** 2,250.00  
**Unit of Measure:** S.F.  
**Estimate:** \$33,192.00  
**Assessor Name:** Eduardo Lopez  
**Date Created:** 01/11/2017

**Notes:** The metal roof covering is aged, showing signs of failure and should be replaced.

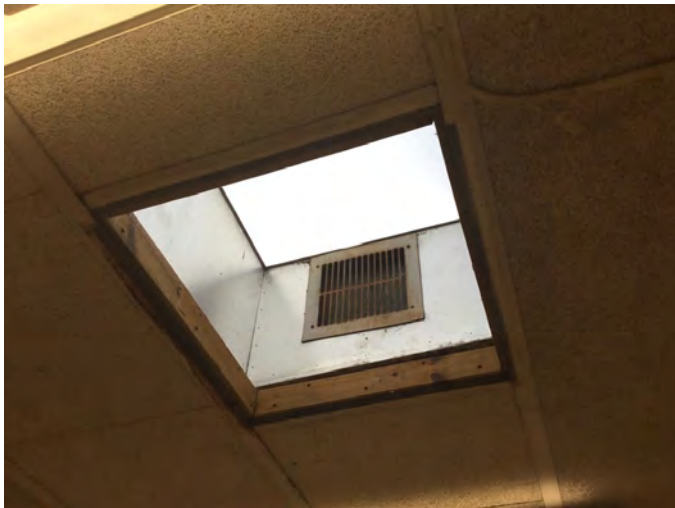
**System: B3020 - Roof Openings**

**Location:** Roof  
**Distress:** Beyond Service Life  
**Category:** Deferred Maintenance  
**Priority:** 3 - Necessary/Not Yet Critical (Years 2-5)  
**Correction:** Renew System  
**Qty:** 28,376.00  
**Unit of Measure:** S.F.  
**Estimate:** \$8,116.00  
**Assessor Name:** Eduardo Lopez  
**Date Created:** 01/11/2017

**Notes:** The roof openings are beyond service life and should be replaced.

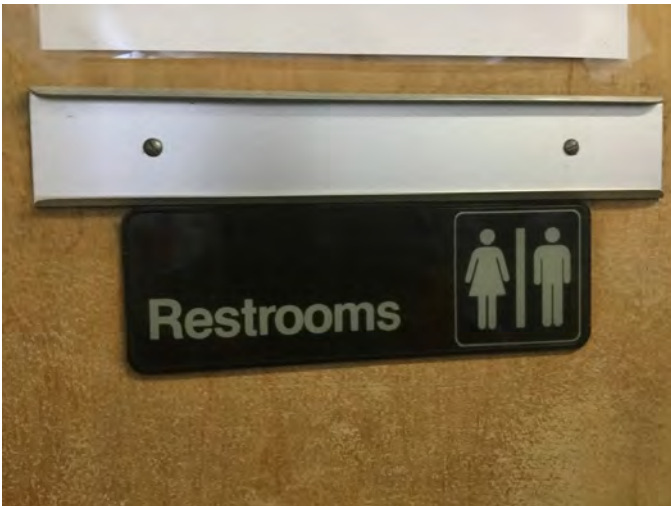
**System: C1030 - Fittings**

**Location:** Throughout the Building  
**Distress:** Beyond Service Life  
**Category:** Deferred Maintenance  
**Priority:** 3 - Necessary/Not Yet Critical (Years 2-5)  
**Correction:** Renew System  
**Qty:** 28,376.00  
**Unit of Measure:** S.F.  
**Estimate:** \$452,909.00  
**Assessor Name:** Eduardo Lopez  
**Date Created:** 01/11/2017

**Notes:** The fittings throughout the building are aged, in marginal condition, handrails and room signage are not ADA compliant and should be replaced.

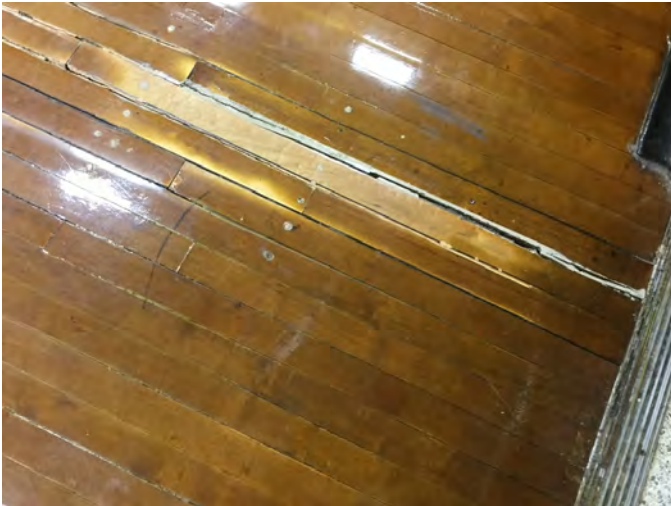
**System: C3020 - Floor Finishes**

**Location:** Throughout the Building  
**Distress:** Beyond Service Life  
**Category:** Deferred Maintenance  
**Priority:** 3 - Necessary/Not Yet Critical (Years 2-5)  
**Correction:** Renew System  
**Qty:** 28,376.00  
**Unit of Measure:** S.F.  
**Estimate:** \$359,581.00  
**Assessor Name:** Eduardo Lopez  
**Date Created:** 01/11/2017

**Notes:** The original flooring is in poor conditions and should be replaced.

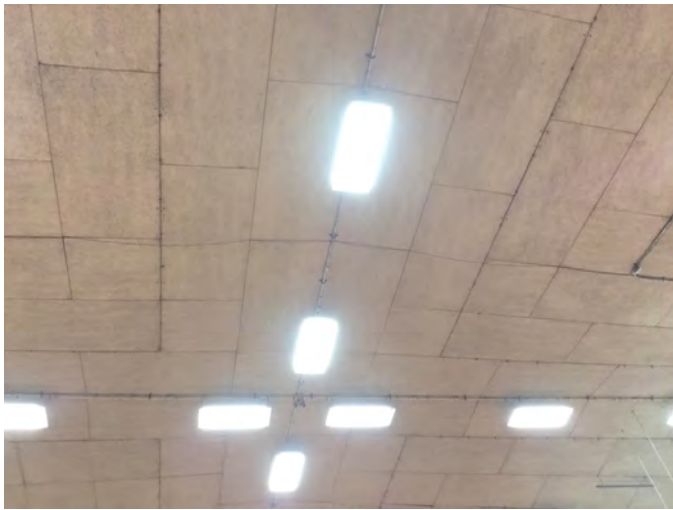
**System: C3030 - Ceiling Finishes**

**Location:** Throughout the Building  
**Distress:** Beyond Service Life  
**Category:** Deferred Maintenance  
**Priority:** 3 - Necessary/Not Yet Critical (Years 2-5)  
**Correction:** Renew System  
**Qty:** 28,376.00  
**Unit of Measure:** S.F.  
**Estimate:** \$392,667.00  
**Assessor Name:** Eduardo Lopez  
**Date Created:** 01/11/2017

**Notes:** The original ceiling finishes are aged, failing and should be replaced.

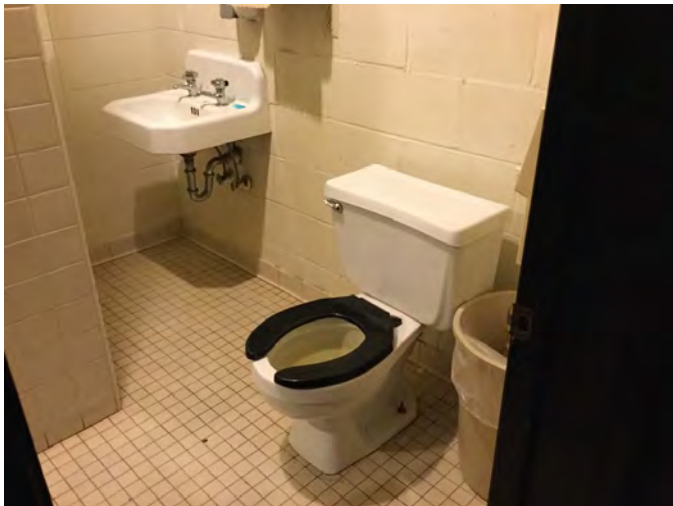
**System: D2010 - Plumbing Fixtures**

**Location:** Throughout the Building  
**Distress:** Beyond Service Life  
**Category:** Deferred Maintenance  
**Priority:** 3 - Necessary/Not Yet Critical (Years 2-5)  
**Correction:** Renew System  
**Qty:** 28,376.00  
**Unit of Measure:** S.F.  
**Estimate:** \$333,049.00  
**Assessor Name:** Eduardo Lopez  
**Date Created:** 01/11/2017

**Notes:** Plumbing fixtures are in operational conditions. However, they are aged, not ADA compliant, and should be scheduled for replacement.

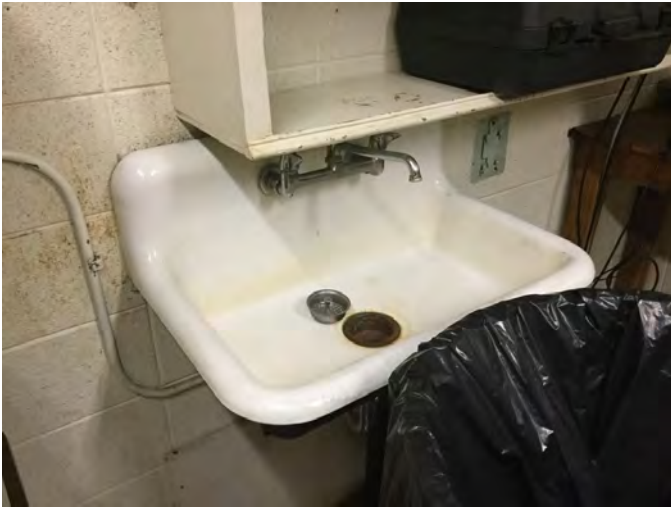
**System: D2020 - Domestic Water Distribution**

**Location:** Throughout the Building  
**Distress:** Beyond Service Life  
**Category:** Deferred Maintenance  
**Priority:** 3 - Necessary/Not Yet Critical (Years 2-5)  
**Correction:** Renew System  
**Qty:** 28,376.00  
**Unit of Measure:** S.F.  
**Estimate:** \$35,584.00  
**Assessor Name:** Eduardo Lopez  
**Date Created:** 01/11/2017

**Notes:** The domestic water distribution system is aged and should be replaced.

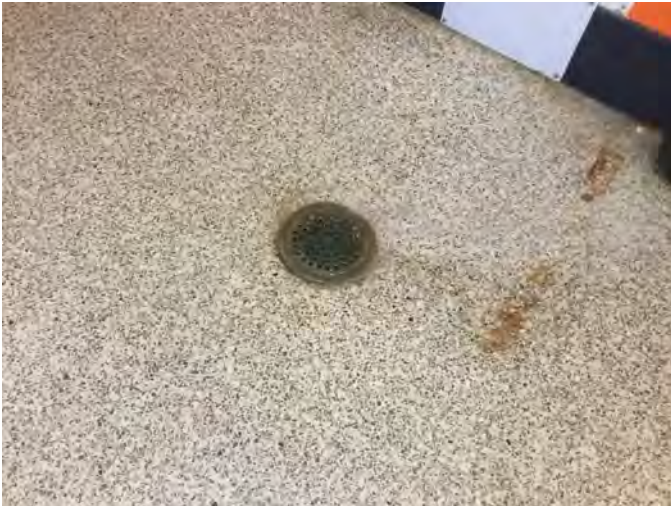
**System: D2030 - Sanitary Waste**

**Location:** Throughout the Building  
**Distress:** Beyond Service Life  
**Category:** Deferred Maintenance  
**Priority:** 3 - Necessary/Not Yet Critical (Years 2-5)  
**Correction:** Renew System  
**Qty:** 28,376.00  
**Unit of Measure:** S.F.  
**Estimate:** \$56,184.00  
**Assessor Name:** Eduardo Lopez  
**Date Created:** 01/11/2017

**Notes:** The sanitary waste system is beyond its expected service life and should be replaced.

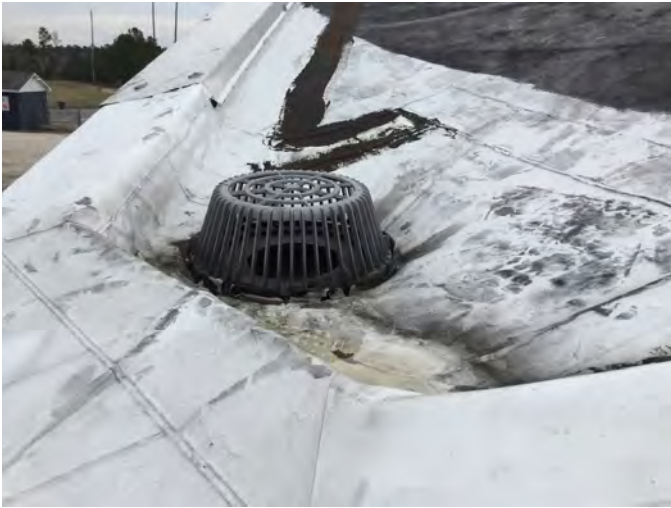
**System: D2040 - Rain Water Drainage**

**Location:** Roof  
**Distress:** Beyond Service Life  
**Category:** Deferred Maintenance  
**Priority:** 3 - Necessary/Not Yet Critical (Years 2-5)  
**Correction:** Renew System  
**Qty:** 28,376.00  
**Unit of Measure:** S.F.  
**Estimate:** \$20,289.00  
**Assessor Name:** Eduardo Lopez  
**Date Created:** 01/11/2017

**Notes:** The rain water drainage system is aged and should be replaced.

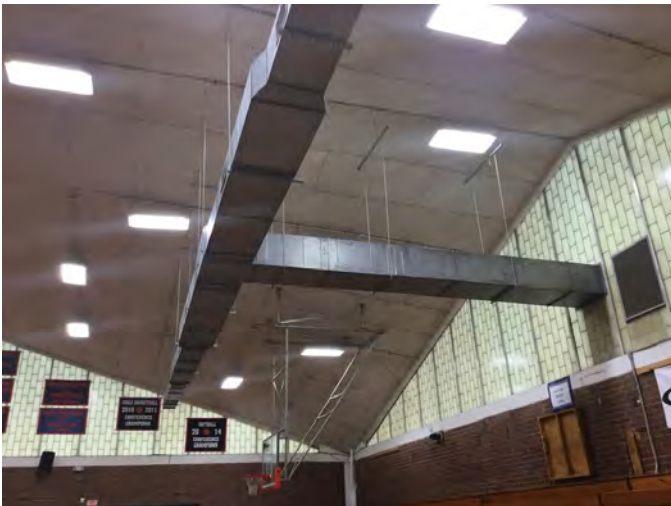
**System: D3040 - Distribution Systems**

**Location:** Throughout the Building  
**Distress:** Beyond Service Life  
**Category:** Deferred Maintenance  
**Priority:** 3 - Necessary/Not Yet Critical (Years 2-5)  
**Correction:** Renew System  
**Qty:** 28,376.00  
**Unit of Measure:** S.F.  
**Estimate:** \$368,008.00  
**Assessor Name:** Eduardo Lopez  
**Date Created:** 01/11/2017

**Notes:** Distribution systems are aged, becoming logistically unsupportable, and should be replaced.

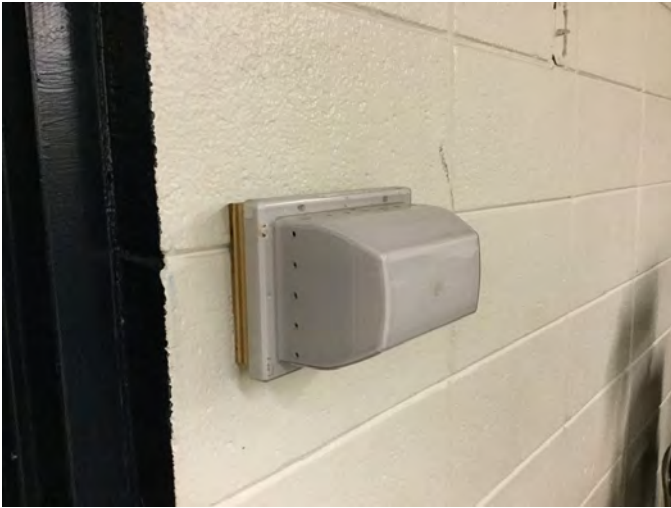
**System: D3060 - Controls & Instrumentation**

**Location:** Throughout the Building  
**Distress:** Beyond Service Life  
**Category:** Deferred Maintenance  
**Priority:** 3 - Necessary/Not Yet Critical (Years 2-5)  
**Correction:** Renew System  
**Qty:** 28,376.00  
**Unit of Measure:** S.F.  
**Estimate:** \$115,490.00  
**Assessor Name:** Eduardo Lopez  
**Date Created:** 01/11/2017

**Notes:** The controls and instrumentation system is in marginal condition and should be schedule for replacement.

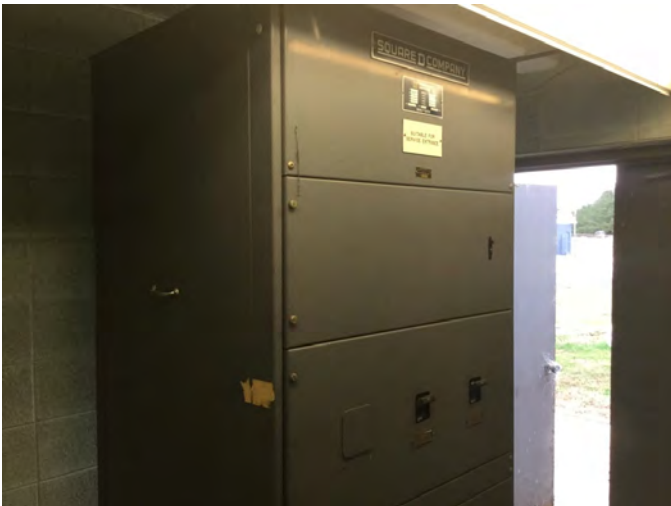
**System: D5010 - Electrical Service/Distribution**

**Location:** Throughout the Building  
**Distress:** Beyond Service Life  
**Category:** Deferred Maintenance  
**Priority:** 3 - Necessary/Not Yet Critical (Years 2-5)  
**Correction:** Renew System  
**Qty:** 28,376.00  
**Unit of Measure:** S.F.  
**Estimate:** \$56,809.00  
**Assessor Name:** Eduardo Lopez  
**Date Created:** 01/11/2017

**Notes:** The original electrical service is operating but is in poor condition and should be replaced.

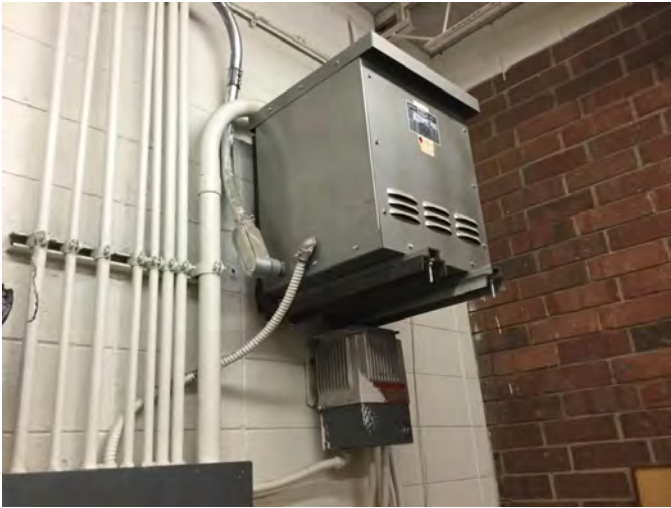
**System: D5020 - Branch Wiring**

**Location:** Throughout the Building  
**Distress:** Beyond Service Life  
**Category:** Deferred Maintenance  
**Priority:** 3 - Necessary/Not Yet Critical (Years 2-5)  
**Correction:** Renew System  
**Qty:** 28,376.00  
**Unit of Measure:** S.F.  
**Estimate:** \$169,490.00  
**Assessor Name:** Eduardo Lopez  
**Date Created:** 01/11/2017

**Notes:** The original branch wiring system is operating but is aged, in marginal condition, and should be replaced.

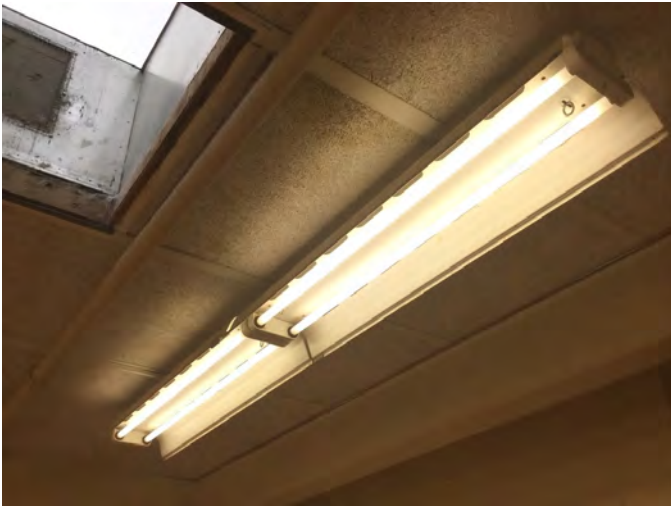
**System: D5020 - Lighting**

**Location:** Throughout the Building  
**Distress:** Beyond Service Life  
**Category:** Deferred Maintenance  
**Priority:** 3 - Necessary/Not Yet Critical (Years 2-5)  
**Correction:** Renew System  
**Qty:** 28,376.00  
**Unit of Measure:** S.F.  
**Estimate:** \$395,164.00  
**Assessor Name:** Eduardo Lopez  
**Date Created:** 01/11/2017

**Notes:** The original branch wiring system is operating but is aged, in marginal condition, and should be replaced.

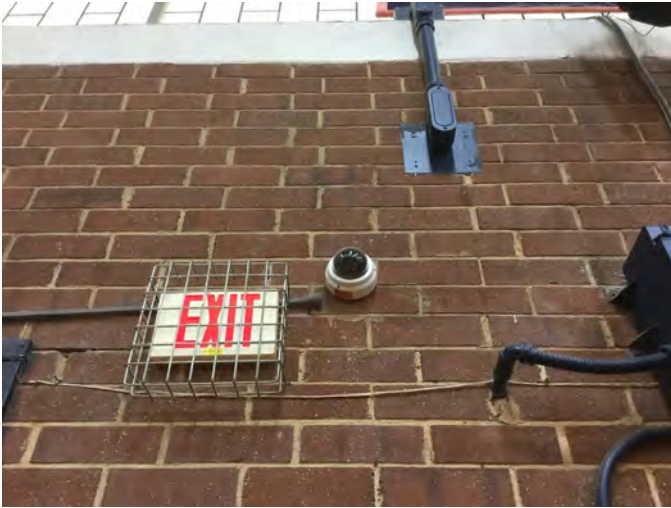
**System: D5030810 - Security & Detection Systems**

**Location:** Throughout the Building  
**Distress:** Beyond Service Life  
**Category:** Deferred Maintenance  
**Priority:** 3 - Necessary/Not Yet Critical (Years 2-5)  
**Correction:** Renew System  
**Qty:** 28,376.00  
**Unit of Measure:** S.F.  
**Estimate:** \$78,346.00  
**Assessor Name:** Eduardo Lopez  
**Date Created:** 01/11/2017

**Notes:** The security and CCTV system is beyond its expected service life and should be scheduled for replacement.

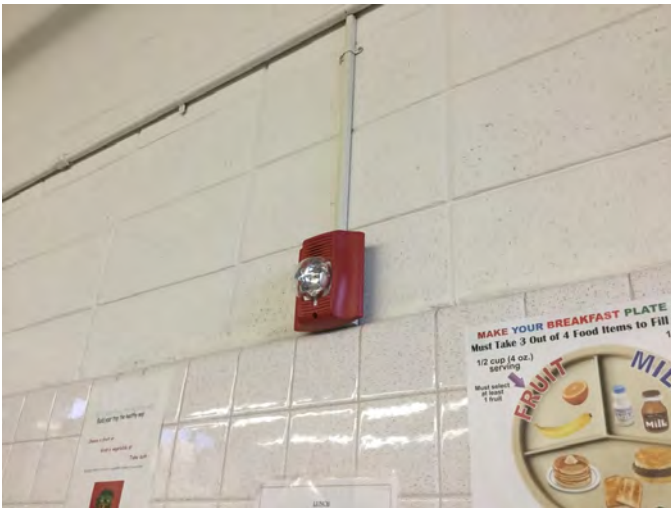
**System: D5030910 - Fire Alarm Systems**

**Location:** Throughout the Building  
**Distress:** Beyond Service Life  
**Category:** Deferred Maintenance  
**Priority:** 3 - Necessary/Not Yet Critical (Years 2-5)  
**Correction:** Renew System  
**Qty:** 28,376.00  
**Unit of Measure:** S.F.  
**Estimate:** \$142,022.00  
**Assessor Name:** Eduardo Lopez  
**Date Created:** 01/11/2017

**Notes:** The fire alarm system is beyond its expected service life and should be scheduled for replacement.

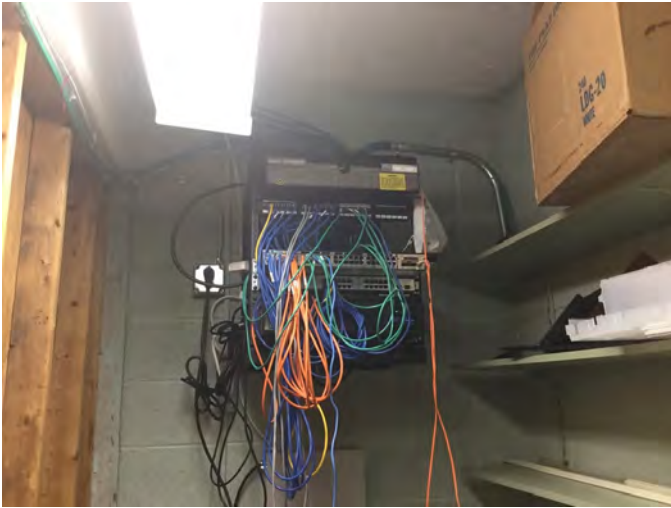
**System: D5030920 - Data Communication**

**Location:** Throughout the Building  
**Distress:** Beyond Service Life  
**Category:** Deferred Maintenance  
**Priority:** 3 - Necessary/Not Yet Critical (Years 2-5)  
**Correction:** Renew System  
**Qty:** 28,376.00  
**Unit of Measure:** S.F.  
**Estimate:** \$183,848.00  
**Assessor Name:** Eduardo Lopez  
**Date Created:** 01/11/2017

**Notes:** The data communication system is beyond its expected service life and should be scheduled for replacement.

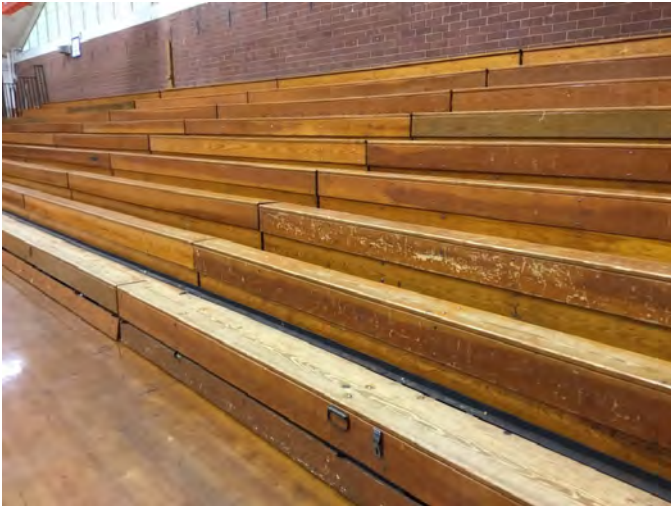
**System: E1090 - Other Equipment**

**Location:** Throughout the building  
**Distress:** Beyond Service Life  
**Category:** Deferred Maintenance  
**Priority:** 3 - Necessary/Not Yet Critical (Years 2-5)  
**Correction:** Renew System  
**Qty:** 28,376.00  
**Unit of Measure:** S.F.  
**Estimate:** \$235,663.00  
**Assessor Name:** Eduardo Lopez  
**Date Created:** 01/11/2017

**Notes:** The other equipment system is beyond service life and should be replaced.

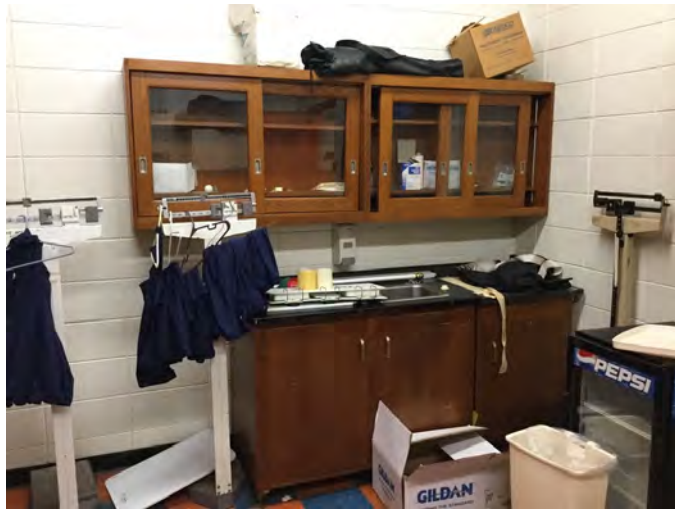
**System: E2010 - Fixed Furnishings**

**Location:** Throughout the Building  
**Distress:** Beyond Service Life  
**Category:** Deferred Maintenance  
**Priority:** 3 - Necessary/Not Yet Critical (Years 2-5)  
**Correction:** Renew System  
**Qty:** 28,376.00  
**Unit of Measure:** S.F.  
**Estimate:** \$188,218.00  
**Assessor Name:** Eduardo Lopez  
**Date Created:** 01/11/2017

**Notes:** The fixed furnishings are aged, in marginal condition, and should be replaced.

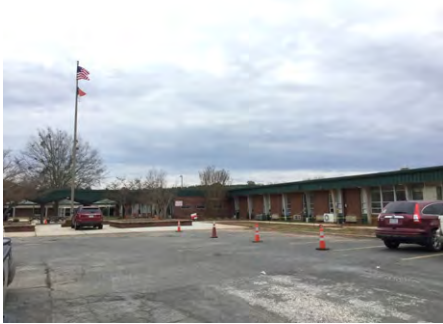
1). Northwest Elevation - Feb 06, 2017

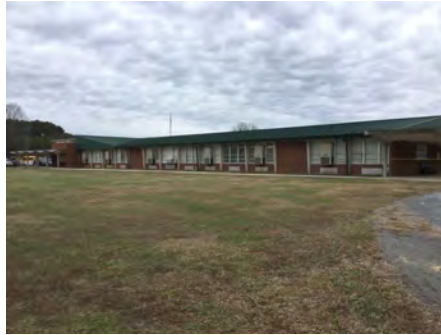
2). West Elevation - Feb 06, 2017

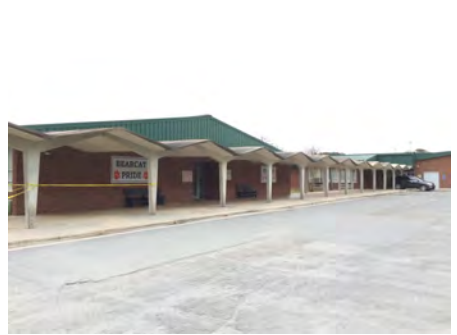
3). Southwest Elevation - Feb 06, 2017

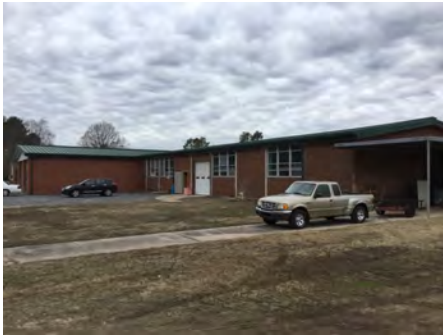
4). Southeast Elevation - Feb 06, 2017

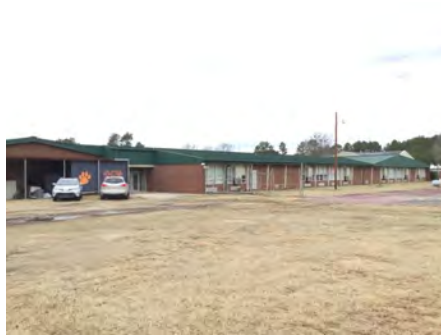
5). East Elevation - Feb 06, 2017

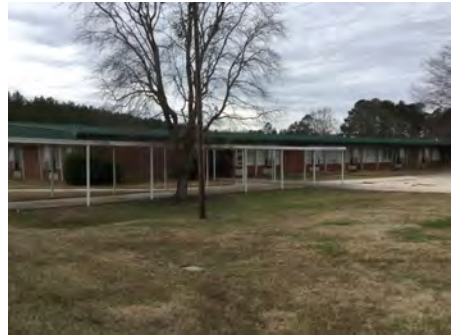
6). Northeast Elevation - Feb 06, 2017

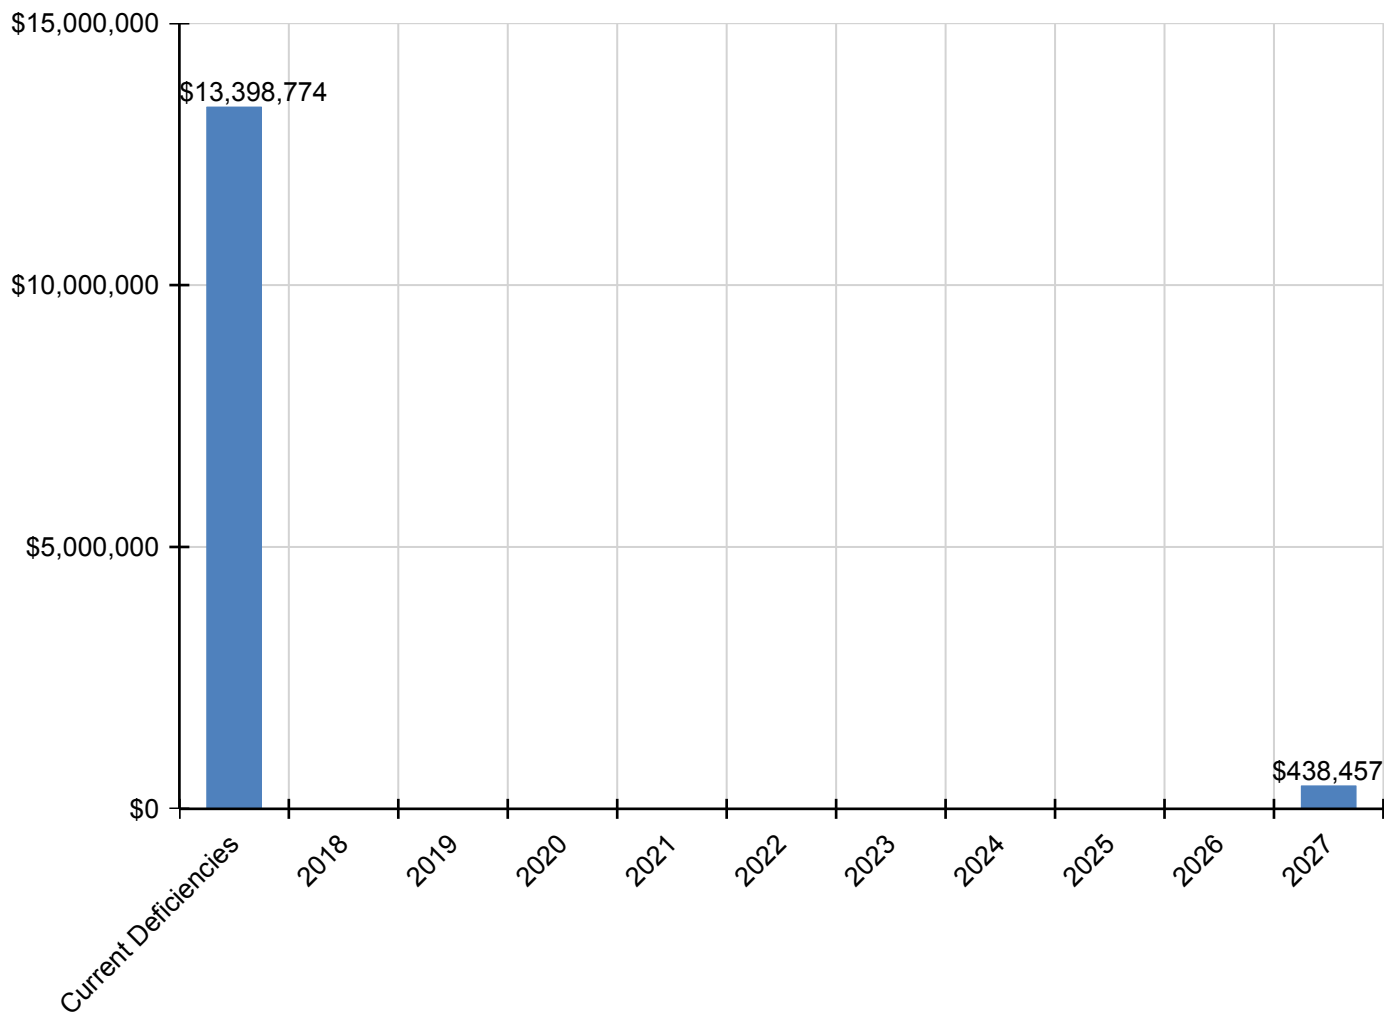
### Forecasted Capital Renewal Requirement

The following chart shows the current building deficiencies and forecasting capital renewal or sustainment requirements over the next ten years.

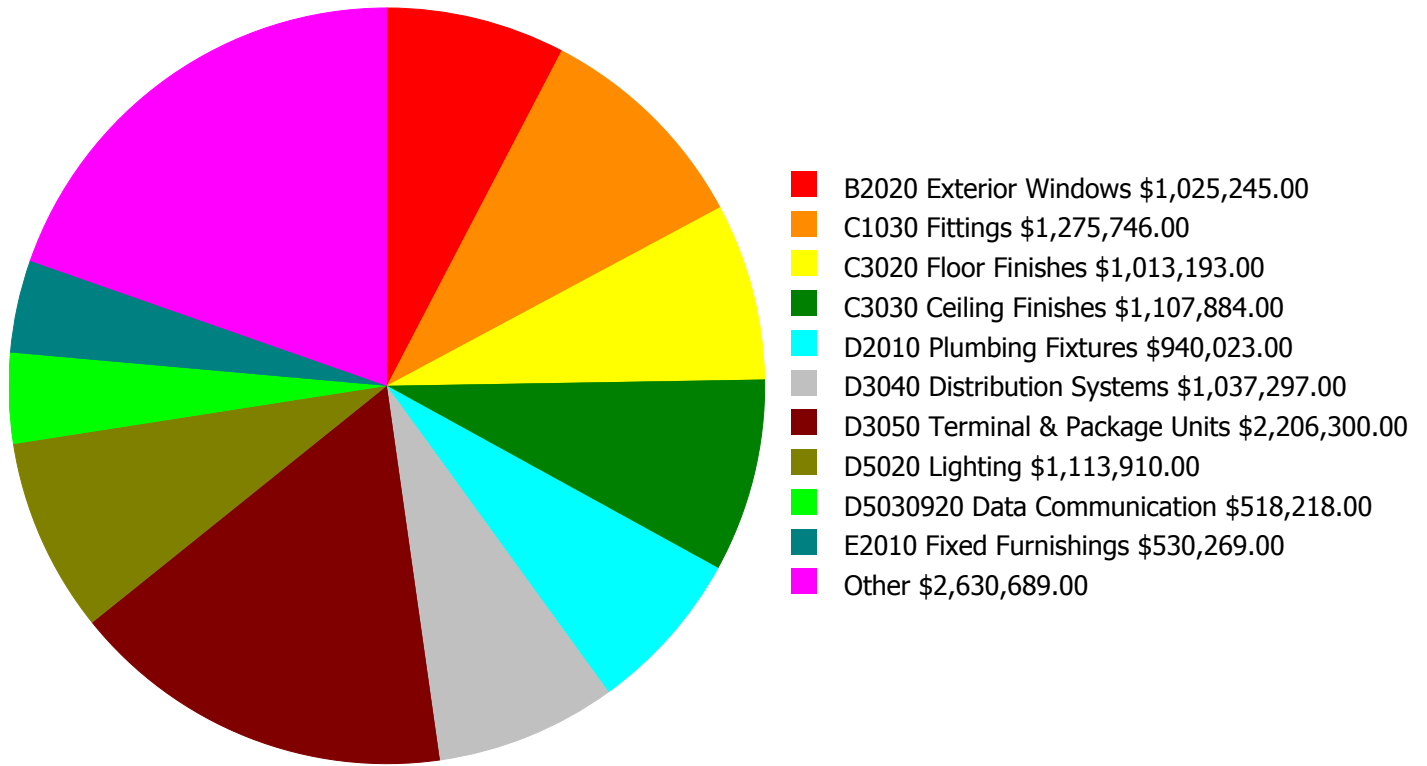
## Deficiency Summary by System

Current deficiencies included assemblies that have reached or exceeded their design life or components of the assemblies that are in need of repair. Assemblies that have reached their design life are identified as current deficiencies and assigned the distress 'Beyond Useful Life'. The following chart lists all current deficiencies associated with this facility.

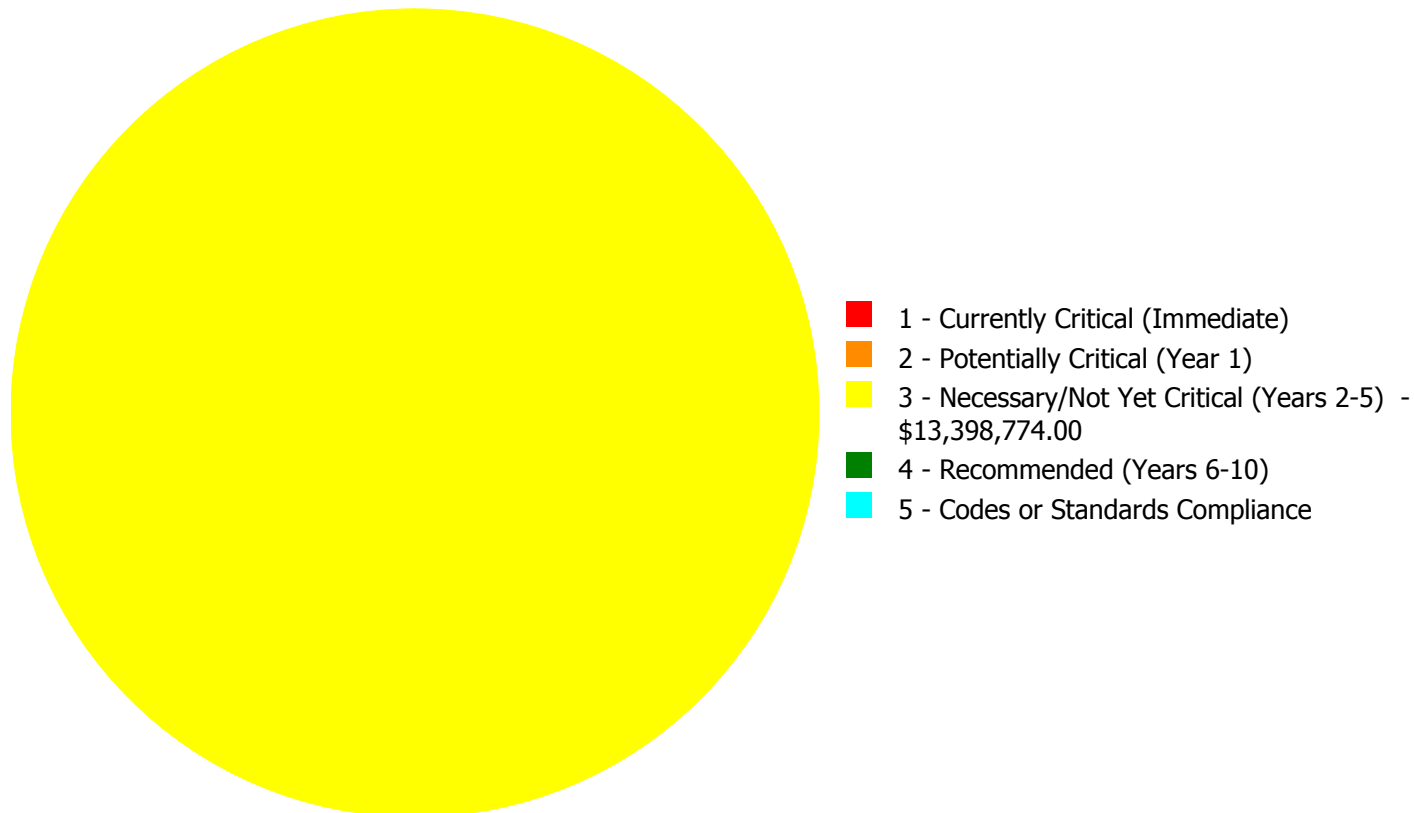
## Deficiency Summary by Priority

The following chart shows the total repair costs broken down by priority. Assessors assigned deficiencies within eCOMET to one of the following priority categories:

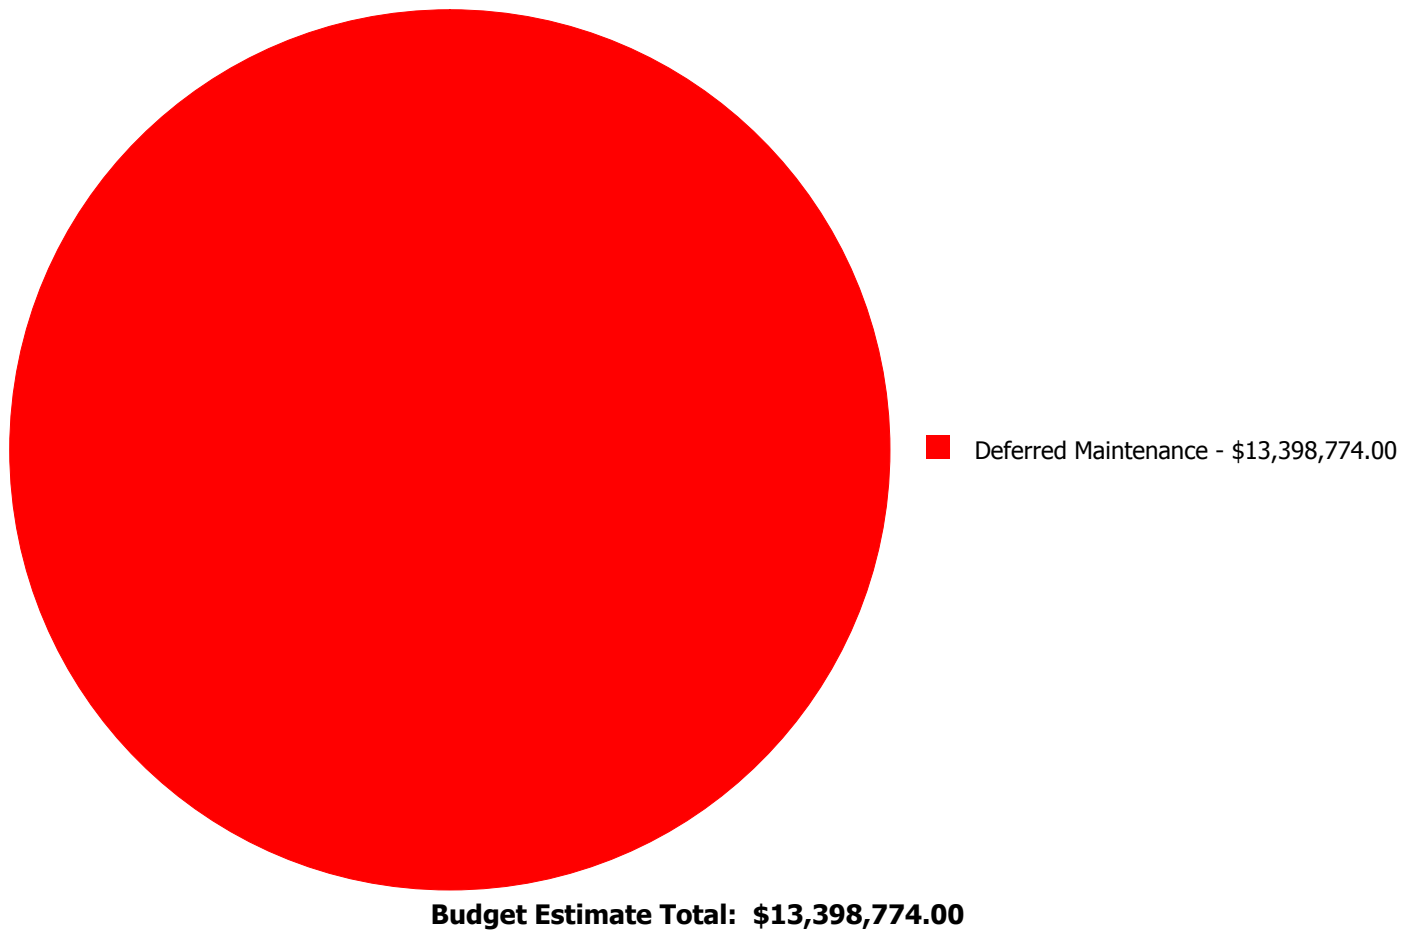
## Deficiency Summary by Category

The following chart shows the total repair costs broken down by deficiency categories. Assessors assigned deficiencies to one of the following categories:

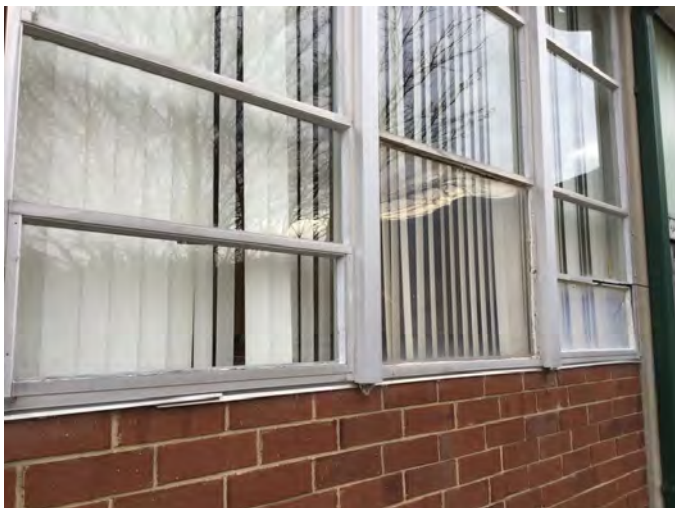
#### System: B2020 - Exterior Windows

**Location:** Exterior Walls  
**Distress:** Beyond Service Life  
**Category:** Deferred Maintenance  
**Priority:** 3 - Necessary/Not Yet Critical (Years 2-5)  
**Correction:** Renew System  
**Qty:** 78,257.00  
**Unit of Measure:** S.F.  
**Estimate:** \$1,025,245.00  
**Assessor Name:** Eduardo Lopez  
**Date Created:** 01/13/2017

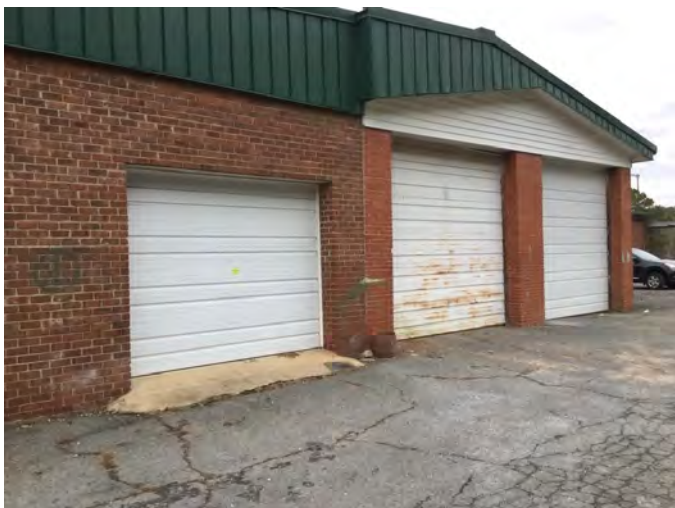
#### System: B2030 - Exterior Doors

**Location:** Exterior Walls  
**Distress:** Beyond Service Life  
**Category:** Deferred Maintenance  
**Priority:** 3 - Necessary/Not Yet Critical (Years 2-5)  
**Correction:** Renew System  
**Qty:** 78,257.00  
**Unit of Measure:** S.F.  
**Estimate:** \$98,995.00  
**Assessor Name:** Eduardo Lopez  
**Date Created:** 01/13/2017

**Notes:** The exterior doors are aged, rusted and should be replaced.

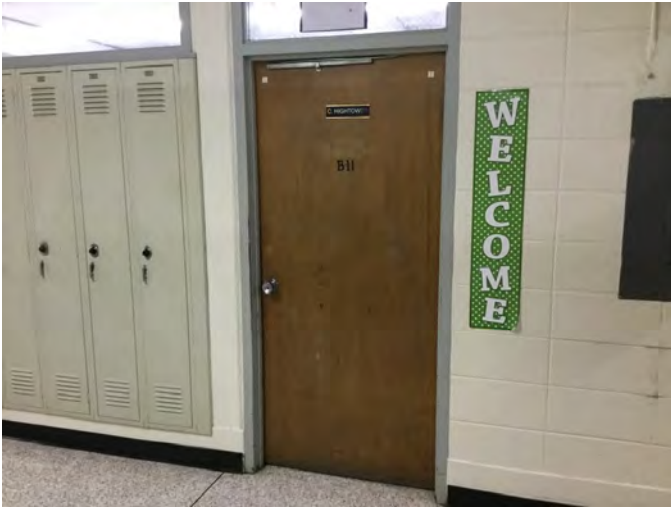
**System: C1020 - Interior Doors**

**Location:** Throughout the Building  
**Distress:** Beyond Service Life  
**Category:** Deferred Maintenance  
**Priority:** 3 - Necessary/Not Yet Critical (Years 2-5)  
**Correction:** Renew System  
**Qty:** 78,257.00  
**Unit of Measure:** S.F.  
**Estimate:** \$240,171.00  
**Assessor Name:** Eduardo Lopez  
**Date Created:** 01/13/2017

**Notes:** The interior doors are aged, failing, most hardware is not ADA or code compliant and should be replaced.

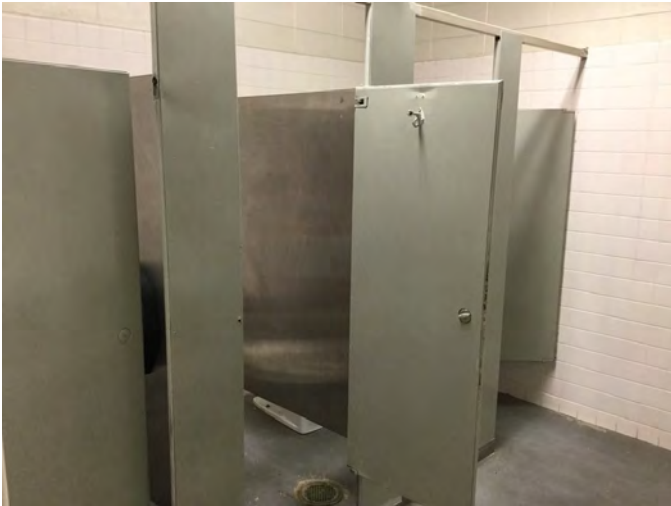
**System: C1030 - Fittings**

**Location:** Throughout the Building  
**Distress:** Beyond Service Life  
**Category:** Deferred Maintenance  
**Priority:** 3 - Necessary/Not Yet Critical (Years 2-5)  
**Correction:** Renew System  
**Qty:** 78,257.00  
**Unit of Measure:** S.F.  
**Estimate:** \$1,275,746.00  
**Assessor Name:** Eduardo Lopez  
**Date Created:** 01/13/2017

**Notes:** The fittings throughout the building are aged, in marginal condition, handrails and room signage are not ADA compliant and should be replaced.

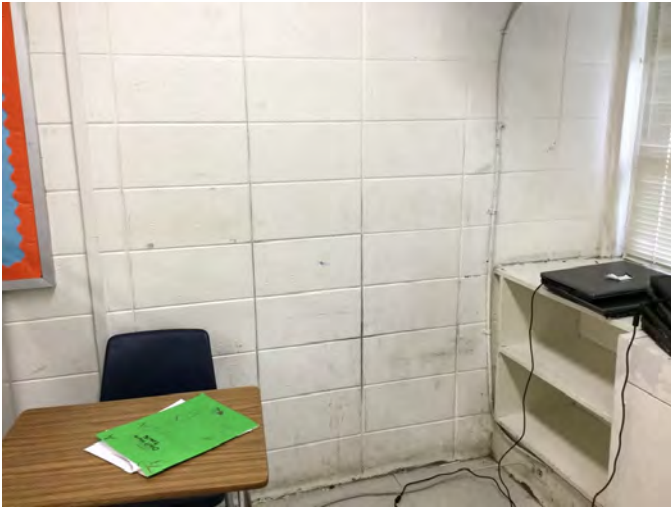
**System: C3010 - Wall Finishes**

**Location:** Throughout the Building  
**Distress:** Beyond Service Life  
**Category:** Deferred Maintenance  
**Priority:** 3 - Necessary/Not Yet Critical (Years 2-5)  
**Correction:** Renew System  
**Qty:** 78,257.00  
**Unit of Measure:** S.F.  
**Estimate:** \$326,253.00  
**Assessor Name:** Eduardo Lopez  
**Date Created:** 01/13/2017

**Notes:** The wall finishes are aged, scuffed, fading, stained and should be replaced.

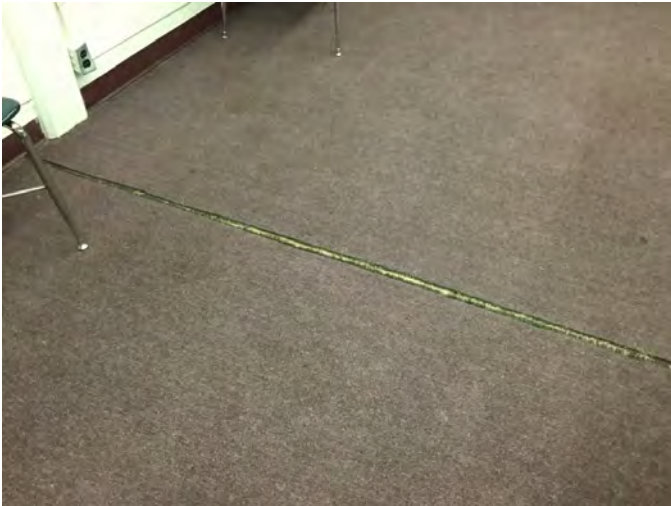
**System: C3020 - Floor Finishes**

**Location:** Throughout the Building  
**Distress:** Beyond Service Life  
**Category:** Deferred Maintenance  
**Priority:** 3 - Necessary/Not Yet Critical (Years 2-5)  
**Correction:** Renew System  
**Qty:** 78,257.00  
**Unit of Measure:** S.F.  
**Estimate:** \$1,013,193.00  
**Assessor Name:** Eduardo Lopez  
**Date Created:** 01/13/2017

**Notes:** The original flooring is in poor conditions and should be replaced.

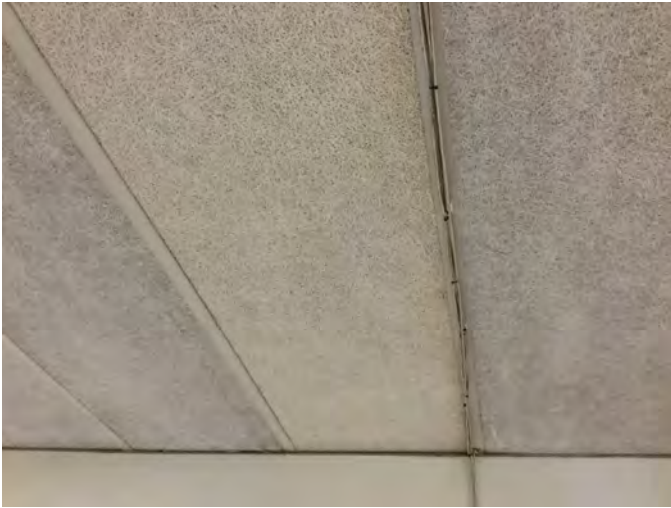
**System: C3030 - Ceiling Finishes**

**Location:** Throughout the Building  
**Distress:** Beyond Service Life  
**Category:** Deferred Maintenance  
**Priority:** 3 - Necessary/Not Yet Critical (Years 2-5)  
**Correction:** Renew System  
**Qty:** 78,257.00  
**Unit of Measure:** S.F.  
**Estimate:** \$1,107,884.00  
**Assessor Name:** Eduardo Lopez  
**Date Created:** 01/13/2017

**Notes:** The original ceiling finishes are aged, failing and should be replaced.

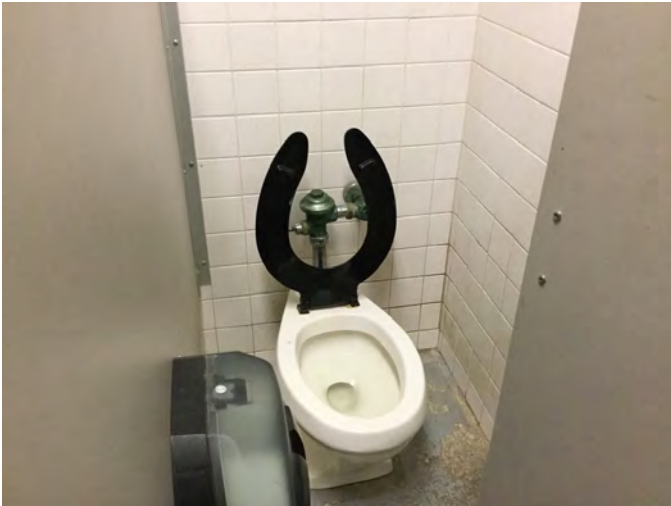
**System: D2010 - Plumbing Fixtures**

**Location:** Throughout the Building  
**Distress:** Beyond Service Life  
**Category:** Deferred Maintenance  
**Priority:** 3 - Necessary/Not Yet Critical (Years 2-5)  
**Correction:** Renew System  
**Qty:** 78,257.00  
**Unit of Measure:** S.F.  
**Estimate:** \$940,023.00  
**Assessor Name:** Eduardo Lopez  
**Date Created:** 01/13/2017

**Notes:** Plumbing fixtures are in operational conditions. However, they are aged, not ADA compliant, and should be scheduled for replacement.

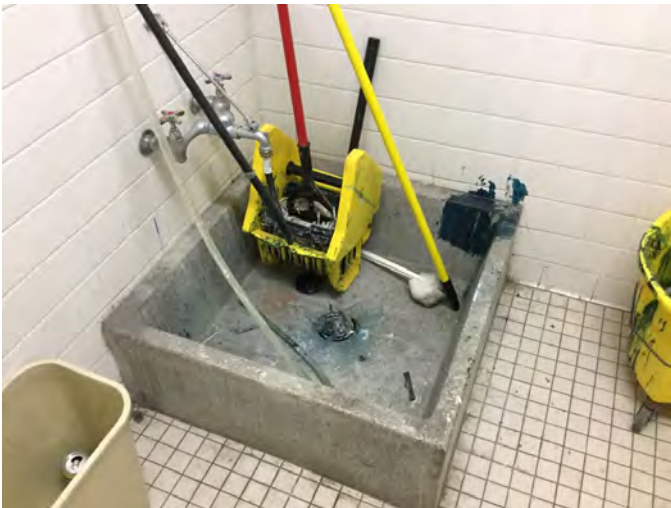
**System: D2030 - Sanitary Waste**

**Location:** Throughout the Building  
**Distress:** Beyond Service Life  
**Category:** Deferred Maintenance  
**Priority:** 3 - Necessary/Not Yet Critical (Years 2-5)  
**Correction:** Renew System  
**Qty:** 78,257.00  
**Unit of Measure:** S.F.  
**Estimate:** \$157,531.00  
**Assessor Name:** Eduardo Lopez  
**Date Created:** 01/13/2017

**Notes:** The sanitary waste system is beyond its expected service life and should be replaced.

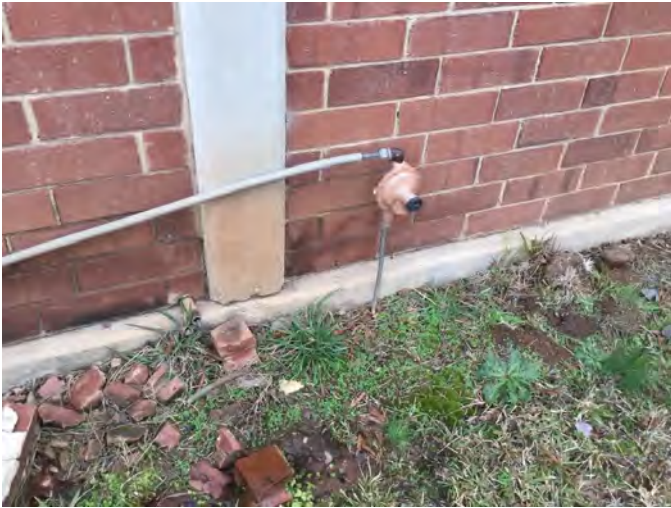
**System: D2090 - Other Plumbing Systems -Nat Gas**

**Location:** Throughout the Building  
**Distress:** Beyond Service Life  
**Category:** Deferred Maintenance  
**Priority:** 3 - Necessary/Not Yet Critical (Years 2-5)  
**Correction:** Renew System  
**Qty:** 78,257.00  
**Unit of Measure:** S.F.  
**Estimate:** \$15,495.00  
**Assessor Name:** Eduardo Lopez  
**Date Created:** 02/06/2017

**Notes:** The natural gas system is beyond its expected service life and should be replaced.

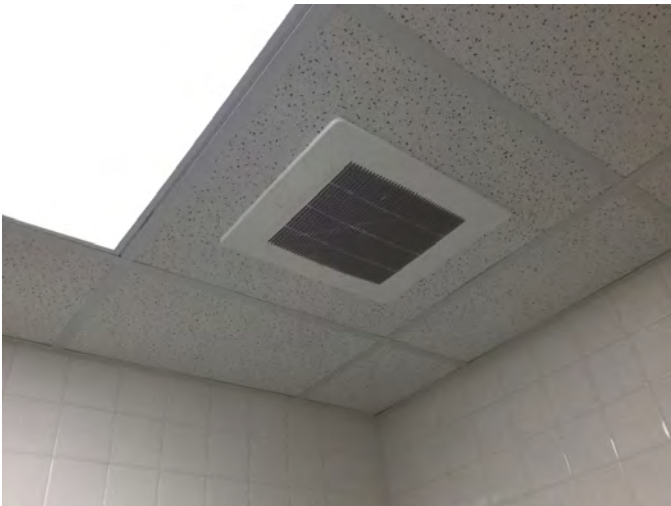
**System: D3040 - Distribution Systems**

**Location:** Throughout the Building  
**Distress:** Beyond Service Life  
**Category:** Deferred Maintenance  
**Priority:** 3 - Necessary/Not Yet Critical (Years 2-5)  
**Correction:** Renew System  
**Qty:** 78,257.00  
**Unit of Measure:** S.F.  
**Estimate:** \$1,037,297.00  
**Assessor Name:** Eduardo Lopez  
**Date Created:** 01/13/2017

**Notes:** Distribution systems are aged, becoming logistically unsupportable, and should be replaced.

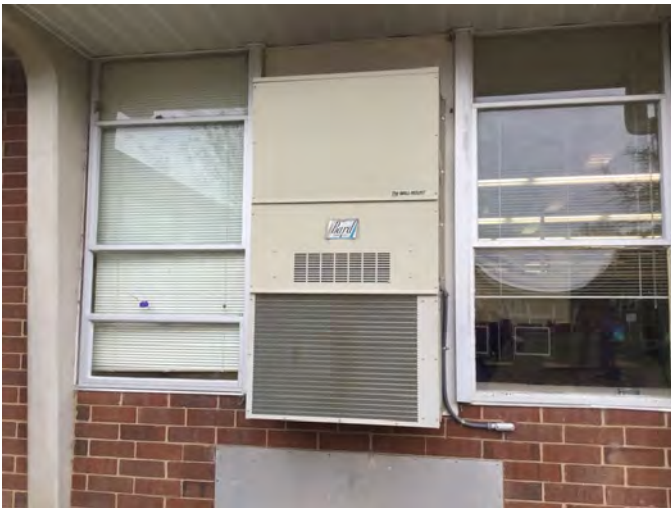
**System: D3050 - Terminal & Package Units**

**Location:** Throughout the Building  
**Distress:** Beyond Service Life  
**Category:** Deferred Maintenance  
**Priority:** 3 - Necessary/Not Yet Critical (Years 2-5)  
**Correction:** Renew System  
**Qty:** 78,257.00  
**Unit of Measure:** S.F.  
**Estimate:** \$2,206,300.00  
**Assessor Name:** Eduardo Lopez  
**Date Created:** 01/13/2017

**Notes:** Terminal and package units are beyond their expected service life and should be scheduled for replacement.

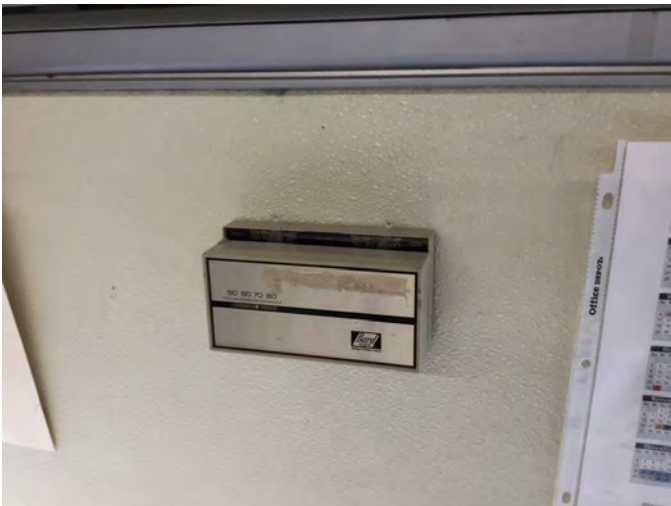
**System: D3060 - Controls & Instrumentation**

**Location:** Throughout the Building  
**Distress:** Beyond Service Life  
**Category:** Deferred Maintenance  
**Priority:** 3 - Necessary/Not Yet Critical (Years 2-5)  
**Correction:** Renew System  
**Qty:** 78,257.00  
**Unit of Measure:** S.F.  
**Estimate:** \$325,393.00  
**Assessor Name:** Eduardo Lopez  
**Date Created:** 01/13/2017

**Notes:** The controls and instrumentation system is in marginal condition and should be schedule for replacement.

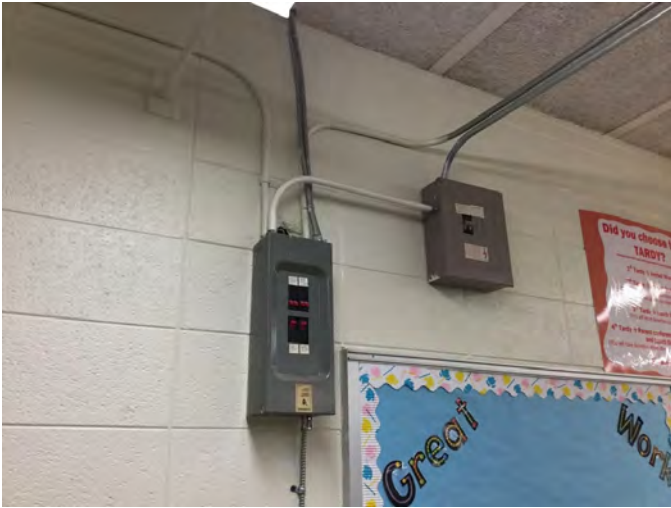
**System: D5020 - Branch Wiring**

**Location:** Throughout the Building  
**Distress:** Beyond Service Life  
**Category:** Deferred Maintenance  
**Priority:** 3 - Necessary/Not Yet Critical (Years 2-5)  
**Correction:** Renew System  
**Qty:** 78,257.00  
**Unit of Measure:** S.F.  
**Estimate:** \$478,620.00  
**Assessor Name:** Eduardo Lopez  
**Date Created:** 01/13/2017

**Notes:** The original branch wiring system is operating but is aged, in marginal condition, and should be replaced.
