# Anson Middle

## Campus Assessment Report

March 7, 2017

## Campus Assessment Report - 1966 Building, Cafe/Gym

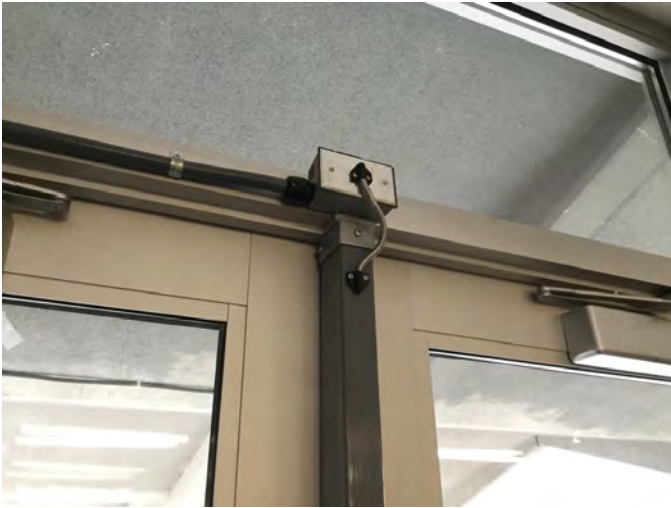
**System: D5030810 - Security & Detection Systems**

**Location:** Throughout the Building  
**Distress:** Beyond Service Life  
**Category:** Deferred Maintenance  
**Priority:** 3 - Necessary/Not Yet Critical (Years 2-5)  
**Correction:** Renew System  
**Qty:** 78,257.00  
**Unit of Measure:** S.F.  
**Estimate:** \$221,233.00  
**Assessor Name:** Eduardo Lopez  
**Date Created:** 01/13/2017

**Notes:** The security and CCTV system is beyond its expected service life and should be scheduled for replacement.

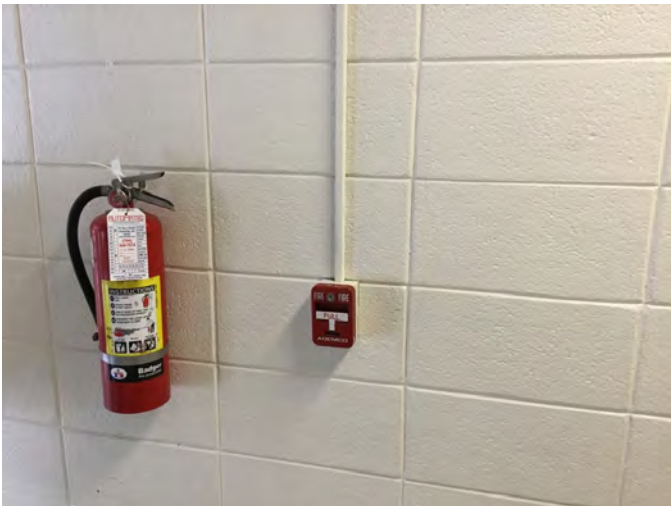
**System: D5030910 - Fire Alarm Systems**

**Location:** Throughout the Building  
**Distress:** Beyond Service Life  
**Category:** Deferred Maintenance  
**Priority:** 3 - Necessary/Not Yet Critical (Years 2-5)  
**Correction:** Renew System  
**Qty:** 78,257.00  
**Unit of Measure:** S.F.  
**Estimate:** \$400,285.00  
**Assessor Name:** Eduardo Lopez  
**Date Created:** 01/13/2017

**Notes:** The fire alarm system is beyond its expected service life and should be scheduled for replacement.

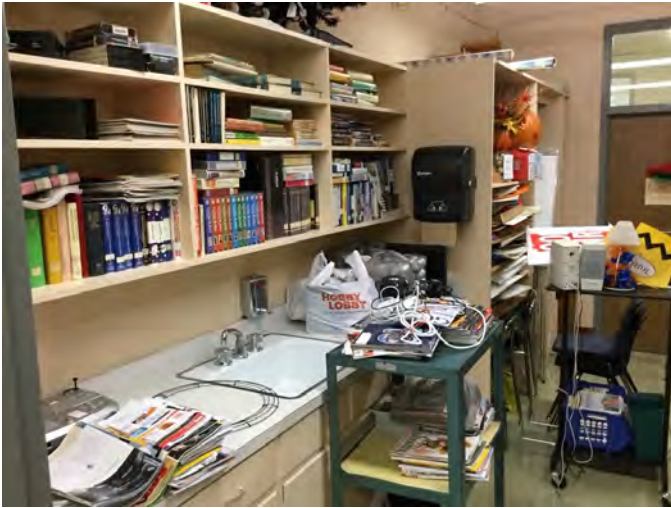
**System: E2010 - Fixed Furnishings**

**Location:** Throughout the Building  
**Distress:** Beyond Service Life  
**Category:** Deferred Maintenance  
**Priority:** 3 - Necessary/Not Yet Critical (Years 2-5)  
**Correction:** Renew System  
**Qty:** 78,257.00  
**Unit of Measure:** S.F.  
**Estimate:** \$530,269.00  
**Assessor Name:** Eduardo Lopez  
**Date Created:** 01/13/2017

**Notes:** The fixed furnishings are aged, in marginal condition, and should be replaced.

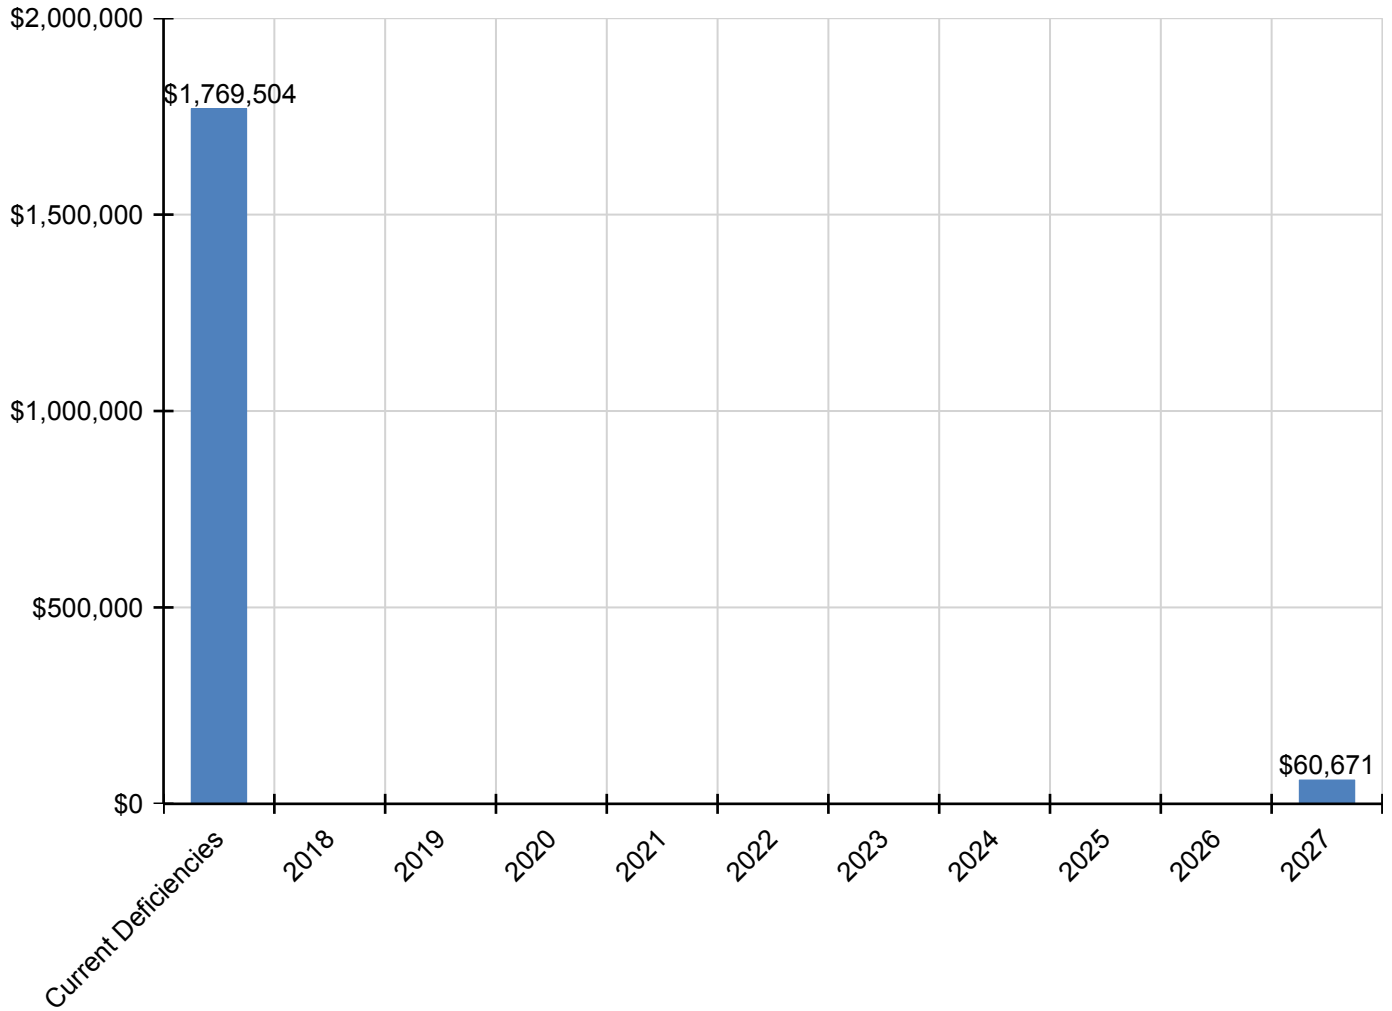
## Forecasted Capital Renewal Requirement

The following chart shows the current building deficiencies and forecasting capital renewal or sustainment requirements over the next ten years.

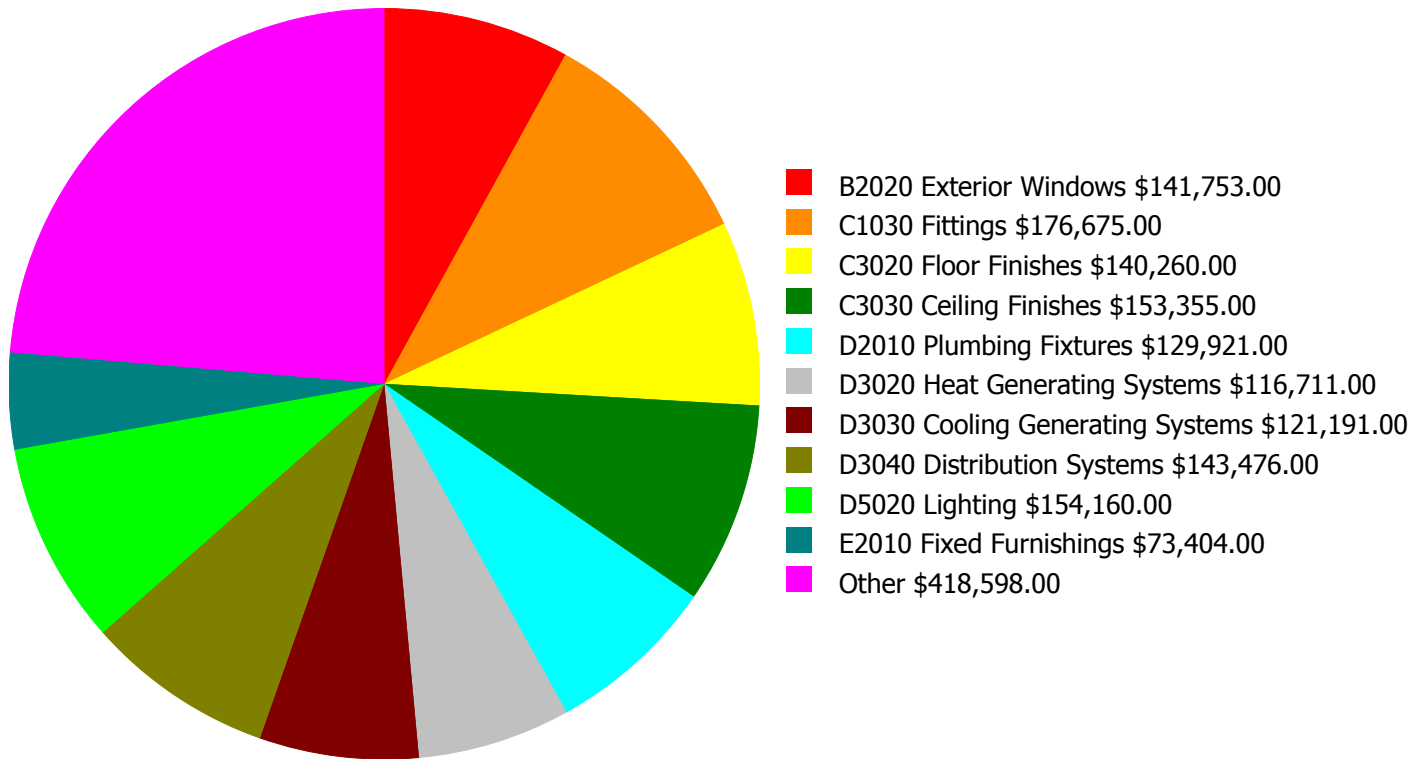
## Deficiency Summary by System

Current deficiencies included assemblies that have reached or exceeded their design life or components of the assemblies that are in need of repair. Assemblies that have reached their design life are identified as current deficiencies and assigned the distress 'Beyond Useful Life'. The following chart lists all current deficiencies associated with this facility.

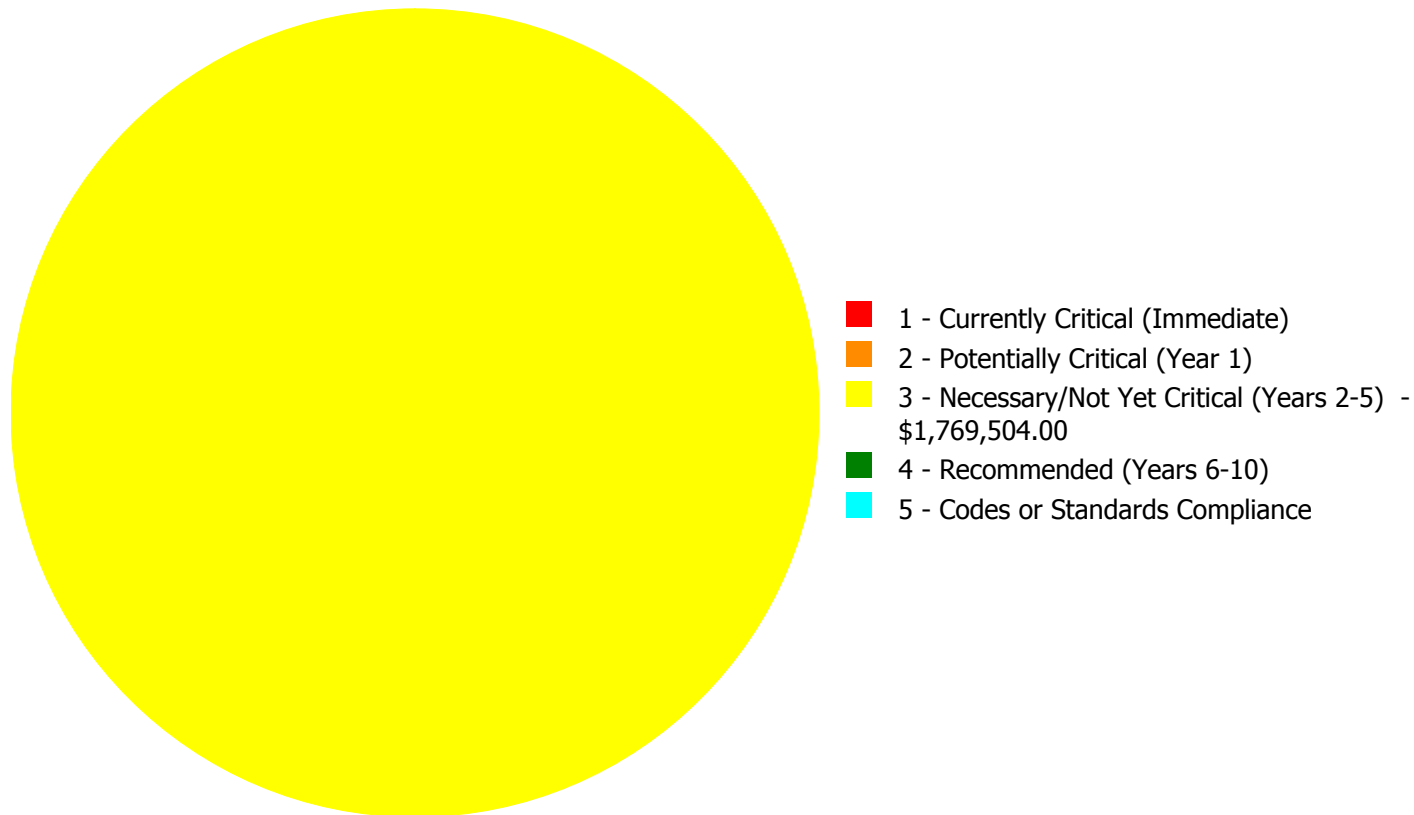
## Deficiency Summary by Priority

The following chart shows the total repair costs broken down by priority. Assessors assigned deficiencies within eCOMET to one of the following priority categories:

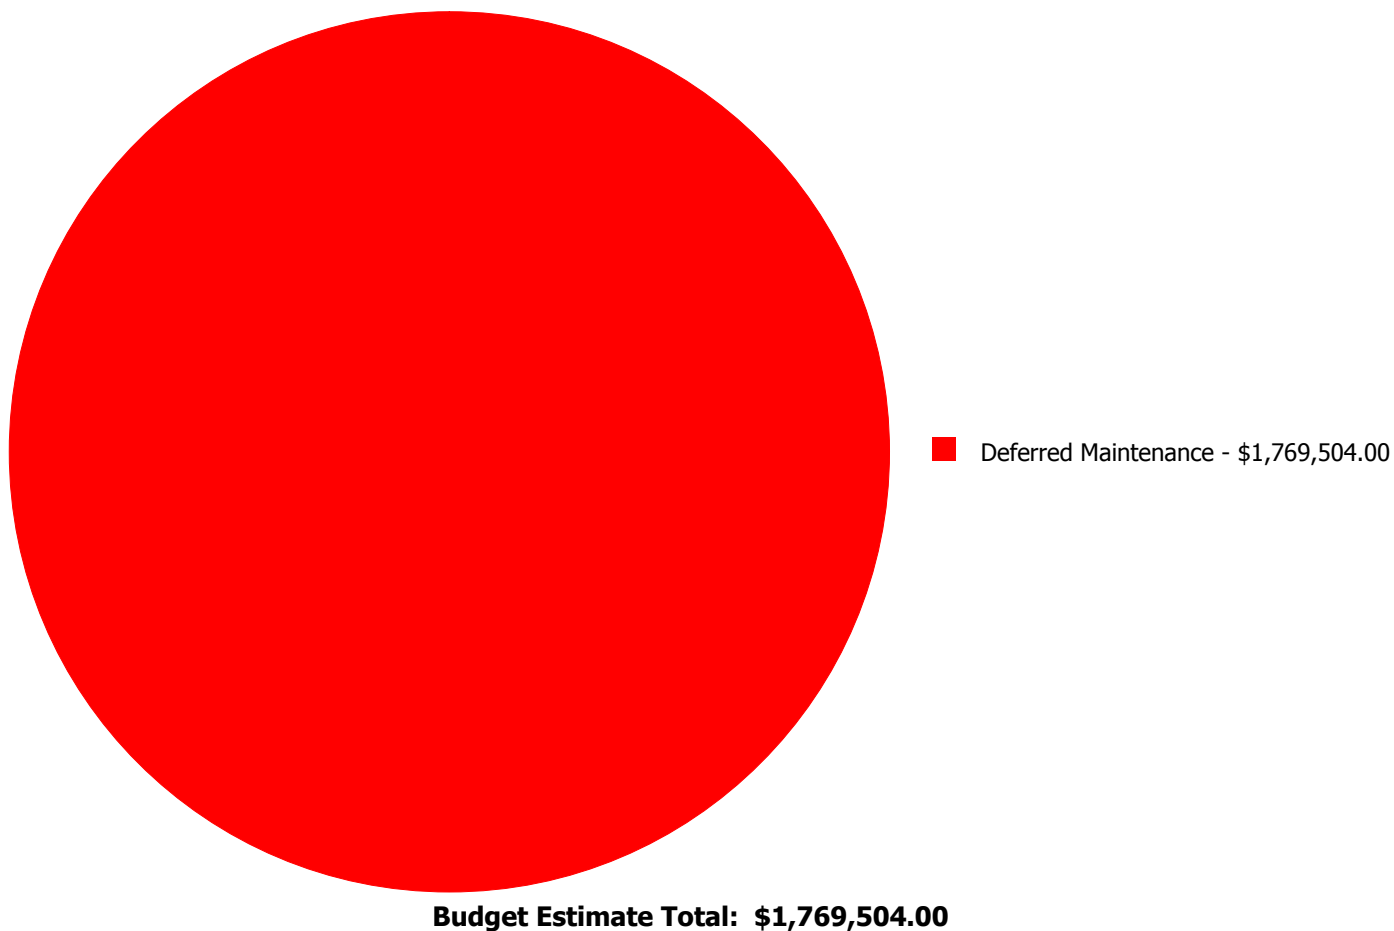
## Deficiency Summary by Category

The following chart shows the total repair costs broken down by deficiency categories. Assessors assigned deficiencies to one of the following categories:

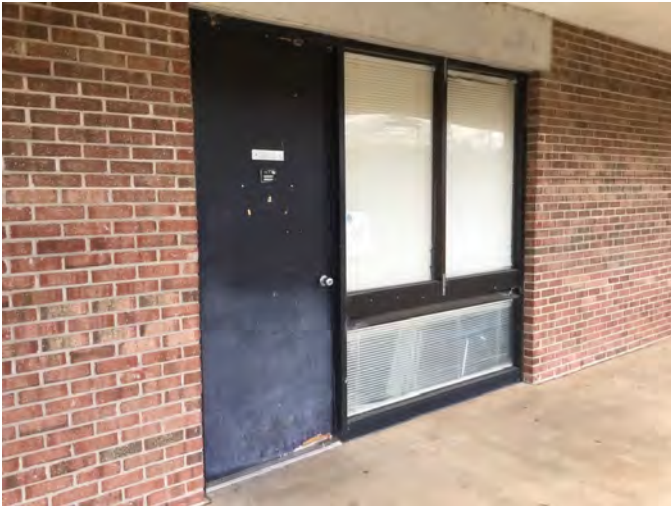
#### System: B2020 - Exterior Windows

**Location:** Exterior Walls  
**Distress:** Beyond Service Life  
**Category:** Deferred Maintenance  
**Priority:** 3 - Necessary/Not Yet Critical (Years 2-5)  
**Correction:** Renew System  
**Qty:** 10,443.00  
**Unit of Measure:** S.F.  
**Estimate:** \$141,753.00  
**Assessor Name:** Eduardo Lopez  
**Date Created:** 02/06/2017

**Notes:** The exterior windows are aged, rusted, not energy efficient and should be replaced.

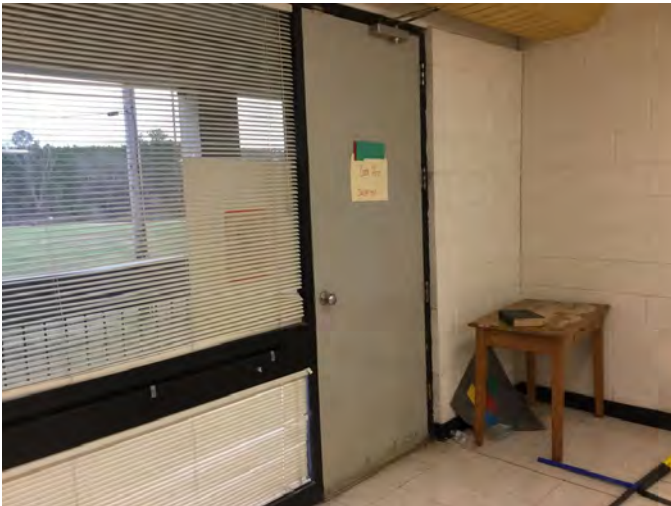
#### System: B2030 - Exterior Doors

**Location:** Exterior Walls  
**Distress:** Beyond Service Life  
**Category:** Deferred Maintenance  
**Priority:** 3 - Necessary/Not Yet Critical (Years 2-5)  
**Correction:** Renew System  
**Qty:** 10,443.00  
**Unit of Measure:** S.F.  
**Estimate:** \$13,785.00  
**Assessor Name:** Eduardo Lopez  
**Date Created:** 02/06/2017

**Notes:** The exterior doors are aged, rusted and should be replaced.

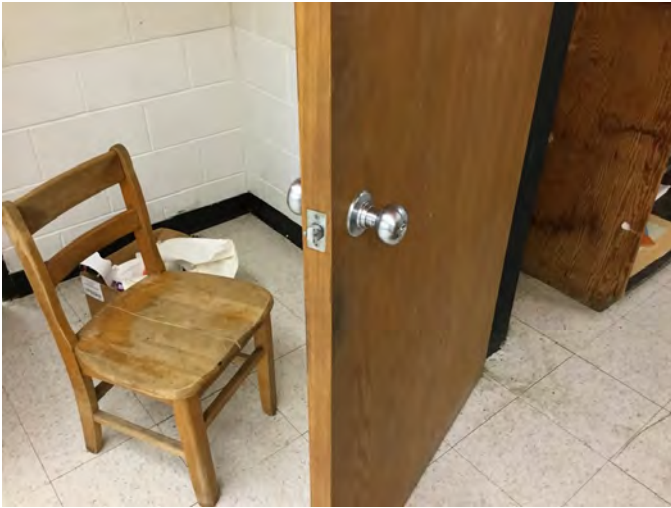
**System: C1020 - Interior Doors**

**Location:** Throughout the Building  
**Distress:** Beyond Service Life  
**Category:** Deferred Maintenance  
**Priority:** 3 - Necessary/Not Yet Critical (Years 2-5)  
**Correction:** Renew System  
**Qty:** 10,443.00  
**Unit of Measure:** S.F.  
**Estimate:** \$33,198.00  
**Assessor Name:** Eduardo Lopez  
**Date Created:** 02/06/2017

**Notes:** The interior doors are aged, failing, most hardware is not ADA or code compliant and should be replaced.

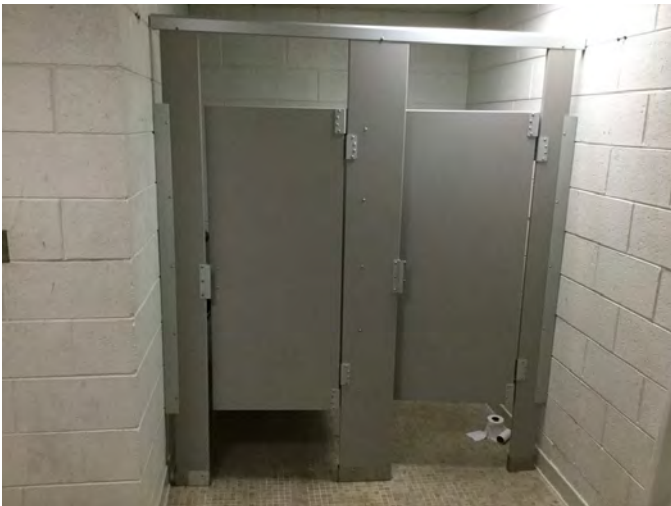
**System: C1030 - Fittings**

**Location:** Throughout the Building  
**Distress:** Beyond Service Life  
**Category:** Deferred Maintenance  
**Priority:** 3 - Necessary/Not Yet Critical (Years 2-5)  
**Correction:** Renew System  
**Qty:** 10,443.00  
**Unit of Measure:** S.F.  
**Estimate:** \$176,675.00  
**Assessor Name:** Eduardo Lopez  
**Date Created:** 02/06/2017

**Notes:** The fittings throughout the building are aged, in marginal condition, handrails and room signage are not ADA compliant and should be replaced.

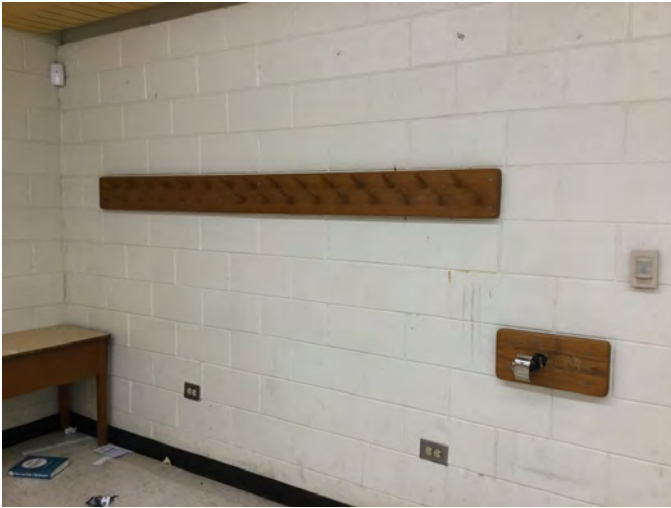
**System: C3010 - Wall Finishes**

**Location:** Throughout the Building  
**Distress:** Beyond Service Life  
**Category:** Deferred Maintenance  
**Priority:** 3 - Necessary/Not Yet Critical (Years 2-5)  
**Correction:** Renew System  
**Qty:** 10,443.00  
**Unit of Measure:** S.F.  
**Estimate:** \$45,145.00  
**Assessor Name:** Eduardo Lopez  
**Date Created:** 02/06/2017

**Notes:** The wall finishes are aged, scuffed, fading, stained and should be replaced.

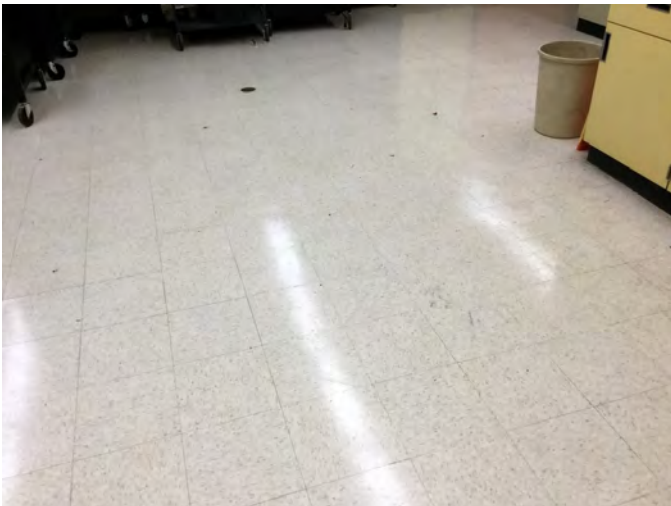
**System: C3020 - Floor Finishes**

**Location:** Throughout the Building  
**Distress:** Beyond Service Life  
**Category:** Deferred Maintenance  
**Priority:** 3 - Necessary/Not Yet Critical (Years 2-5)  
**Correction:** Renew System  
**Qty:** 10,443.00  
**Unit of Measure:** S.F.  
**Estimate:** \$140,260.00  
**Assessor Name:** Eduardo Lopez  
**Date Created:** 02/06/2017

**Notes:** The original flooring is in poor conditions and should be replaced.

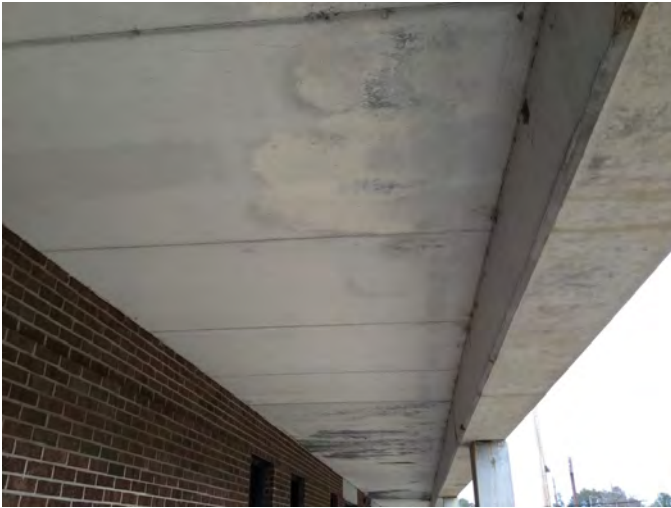
**System: C3030 - Ceiling Finishes**

**Location:** Throughout the Building  
**Distress:** Beyond Service Life  
**Category:** Deferred Maintenance  
**Priority:** 3 - Necessary/Not Yet Critical (Years 2-5)  
**Correction:** Renew System  
**Qty:** 10,443.00  
**Unit of Measure:** S.F.  
**Estimate:** \$153,355.00  
**Assessor Name:** Eduardo Lopez  
**Date Created:** 02/06/2017

**Notes:** The original ceiling finishes are aged, failing and should be replaced.

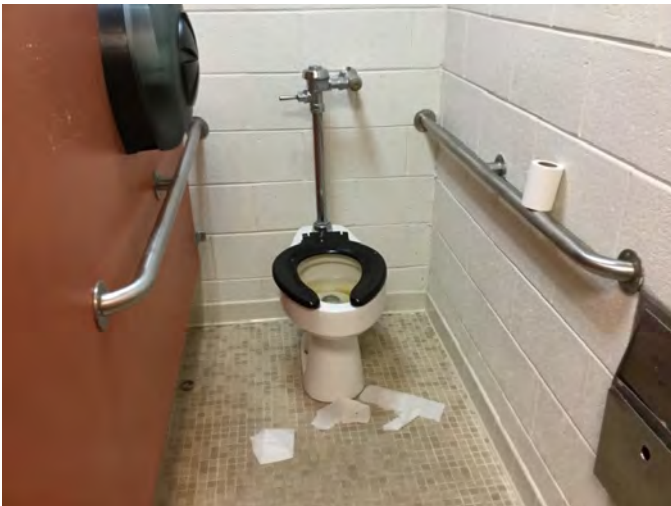
**System: D2010 - Plumbing Fixtures**

**Location:** Throughout the Building  
**Distress:** Beyond Service Life  
**Category:** Deferred Maintenance  
**Priority:** 3 - Necessary/Not Yet Critical (Years 2-5)  
**Correction:** Renew System  
**Qty:** 10,443.00  
**Unit of Measure:** S.F.  
**Estimate:** \$129,921.00  
**Assessor Name:** Eduardo Lopez  
**Date Created:** 02/06/2017

**Notes:** Plumbing fixtures are in operational conditions. However, they are aged, not ADA compliant, and should be scheduled for replacement.

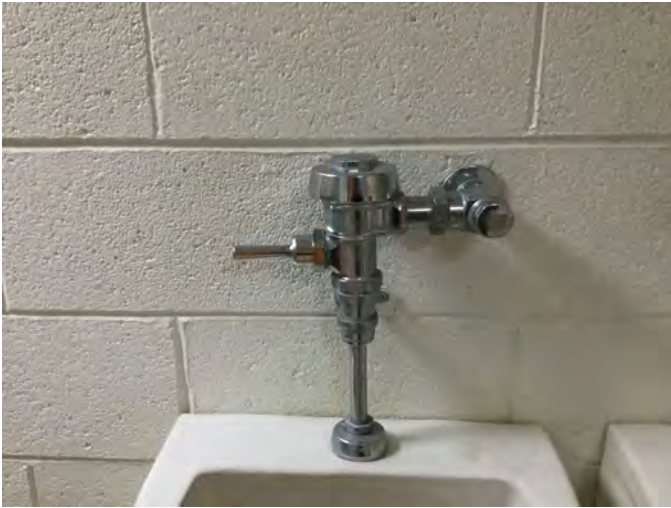
**System: D2020 - Domestic Water Distribution**

**Location:** Throughout the Building  
**Distress:** Beyond Service Life  
**Category:** Deferred Maintenance  
**Priority:** 3 - Necessary/Not Yet Critical (Years 2-5)  
**Correction:** Renew System  
**Qty:** 10,443.00  
**Unit of Measure:** S.F.  
**Estimate:** \$13,900.00  
**Assessor Name:** Eduardo Lopez  
**Date Created:** 02/06/2017

**Notes:** The domestic water distribution system is aged and should be replaced.

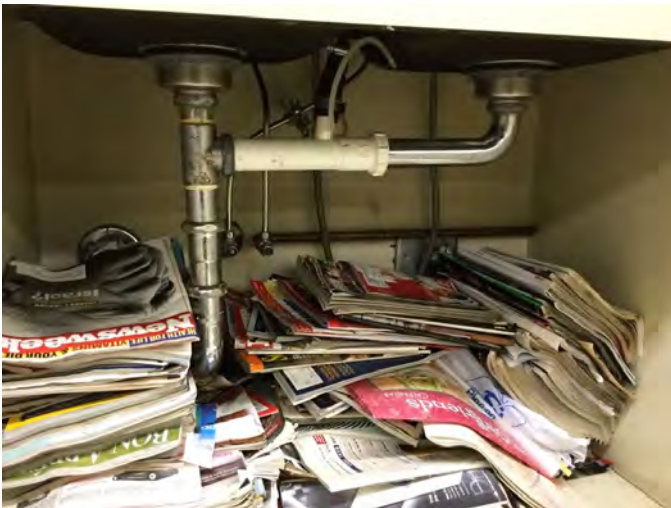
**System: D2030 - Sanitary Waste**

**Location:** Throughout the Building  
**Distress:** Beyond Service Life  
**Category:** Deferred Maintenance  
**Priority:** 3 - Necessary/Not Yet Critical (Years 2-5)  
**Correction:** Renew System  
**Qty:** 10,443.00  
**Unit of Measure:** S.F.  
**Estimate:** \$21,826.00  
**Assessor Name:** Eduardo Lopez  
**Date Created:** 02/06/2017

**Notes:** The sanitary waste system is beyond its expected service life and should be replaced.

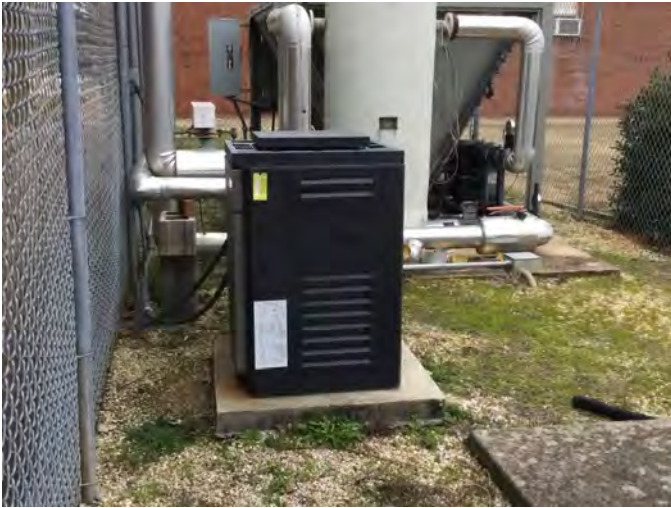
**System: D3020 - Heat Generating Systems**

**Location:** Throughout the Building  
**Distress:** Beyond Service Life  
**Category:** Deferred Maintenance  
**Priority:** 3 - Necessary/Not Yet Critical (Years 2-5)  
**Correction:** Renew System  
**Qty:** 10,443.00  
**Unit of Measure:** S.F.  
**Estimate:** \$116,711.00  
**Assessor Name:** Eduardo Lopez  
**Date Created:** 02/06/2017

**Notes:** The gas-fired boiler is operational and in fair condition, but inefficient, becoming logistically unsupportable, and should be replaced with an energy efficient model.

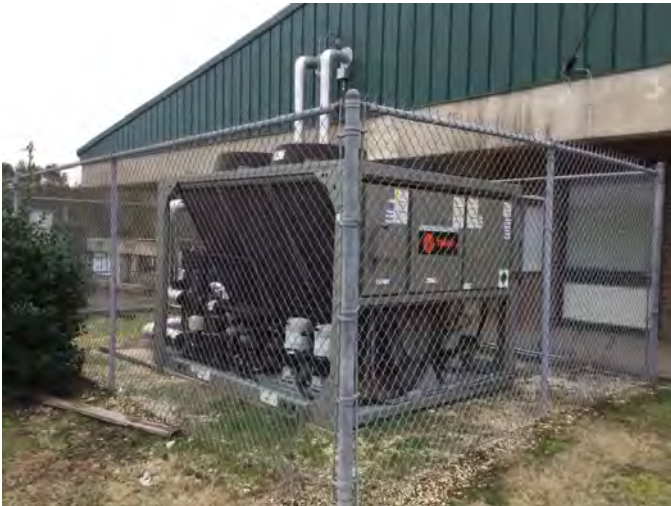
**System: D3030 - Cooling Generating Systems**

**Location:** Throughout the Building  
**Distress:** Beyond Service Life  
**Category:** Deferred Maintenance  
**Priority:** 3 - Necessary/Not Yet Critical (Years 2-5)  
**Correction:** Renew System  
**Qty:** 10,443.00  
**Unit of Measure:** S.F.  
**Estimate:** \$121,191.00  
**Assessor Name:** Eduardo Lopez  
**Date Created:** 02/06/2017

**Notes:** The cooling generating system is beyond its expected service life and should be scheduled for replacement.

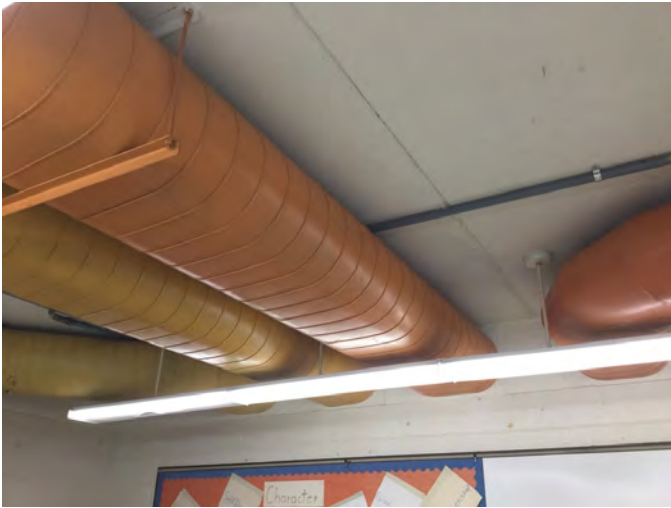
**System: D3040 - Distribution Systems**

**Location:** Throughout the Building  
**Distress:** Beyond Service Life  
**Category:** Deferred Maintenance  
**Priority:** 3 - Necessary/Not Yet Critical (Years 2-5)  
**Correction:** Renew System  
**Qty:** 10,443.00  
**Unit of Measure:** S.F.  
**Estimate:** \$143,476.00  
**Assessor Name:** Eduardo Lopez  
**Date Created:** 02/06/2017

**Notes:** The distribution systems are aged, becoming logistically unsupportable, and should be replaced.

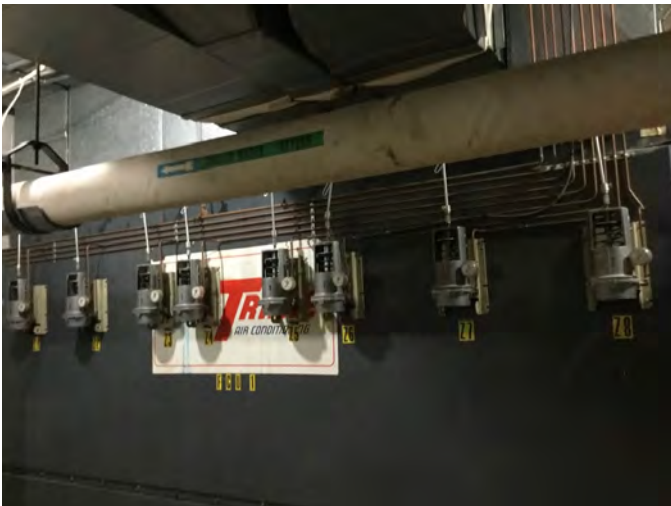
**System: D3060 - Controls & Instrumentation**

**Location:** Throughout the Building  
**Distress:** Beyond Service Life  
**Category:** Deferred Maintenance  
**Priority:** 3 - Necessary/Not Yet Critical (Years 2-5)  
**Correction:** Renew System  
**Qty:** 10,443.00  
**Unit of Measure:** S.F.  
**Estimate:** \$44,915.00  
**Assessor Name:** Eduardo Lopez  
**Date Created:** 02/06/2017

**Notes:** The controls and instrumentation system is in marginal condition and should be schedule for replacement.

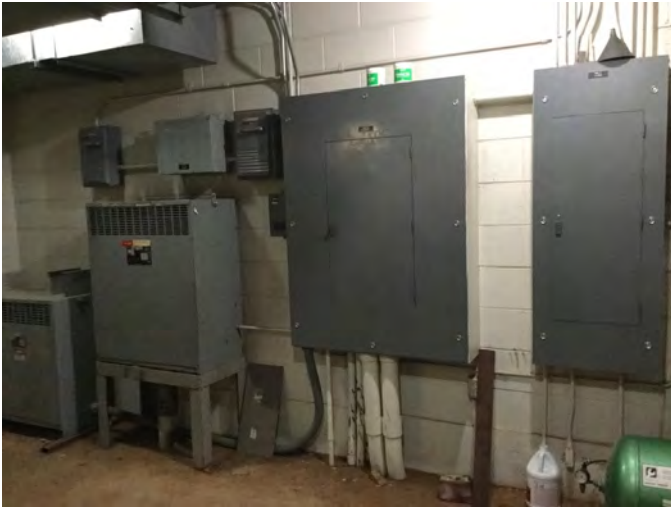
**System: D5010 - Electrical Service/Distribution**

**Location:** Throughout the Building  
**Distress:** Beyond Service Life  
**Category:** Deferred Maintenance  
**Priority:** 3 - Necessary/Not Yet Critical (Years 2-5)  
**Correction:** Renew System  
**Qty:** 10,443.00  
**Unit of Measure:** S.F.  
**Estimate:** \$21,941.00  
**Assessor Name:** Eduardo Lopez  
**Date Created:** 02/06/2017

**Notes:** The original electrical service is operating but is in poor condition and should be replaced.

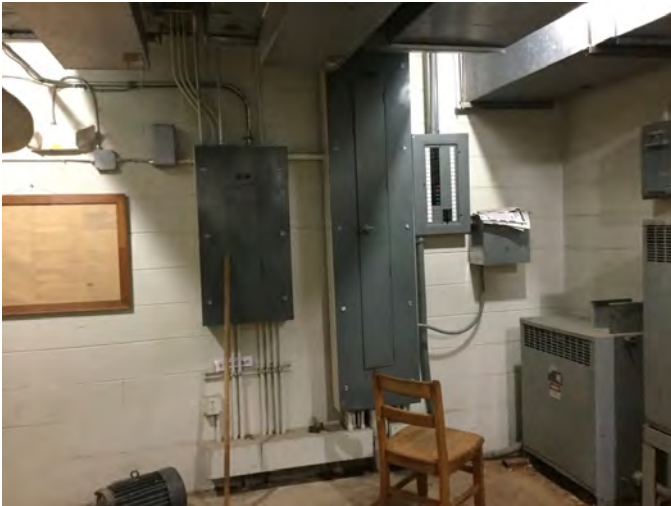
**System: D5020 - Branch Wiring**

**Location:** Throughout the Building  
**Distress:** Beyond Service Life  
**Category:** Deferred Maintenance  
**Priority:** 3 - Necessary/Not Yet Critical (Years 2-5)  
**Correction:** Renew System  
**Qty:** 10,443.00  
**Unit of Measure:** S.F.  
**Estimate:** \$66,167.00  
**Assessor Name:** Eduardo Lopez  
**Date Created:** 02/06/2017

**Notes:** The original branch wiring system is operating but is aged, in marginal condition, and should be replaced.

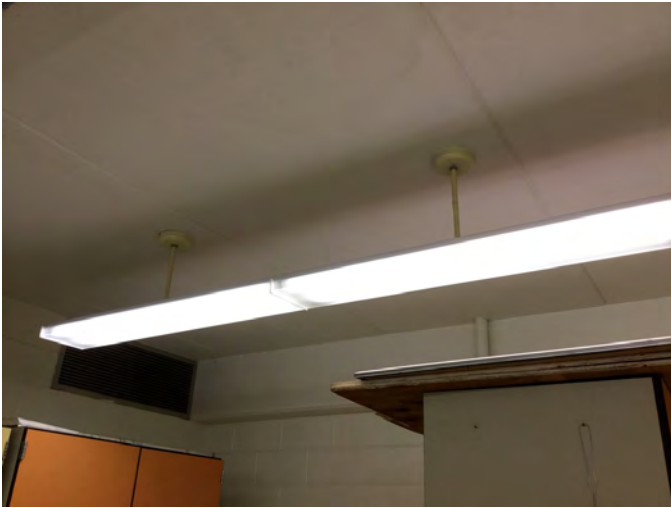
**System: D5020 - Lighting**

**Location:** Throughout the Building  
**Distress:** Beyond Service Life  
**Category:** Deferred Maintenance  
**Priority:** 3 - Necessary/Not Yet Critical (Years 2-5)  
**Correction:** Renew System  
**Qty:** 10,443.00  
**Unit of Measure:** S.F.  
**Estimate:** \$154,160.00  
**Assessor Name:** Eduardo Lopez  
**Date Created:** 02/06/2017

**Notes:** The original branch wiring system is operating but is aged, in marginal condition, and should be replaced.

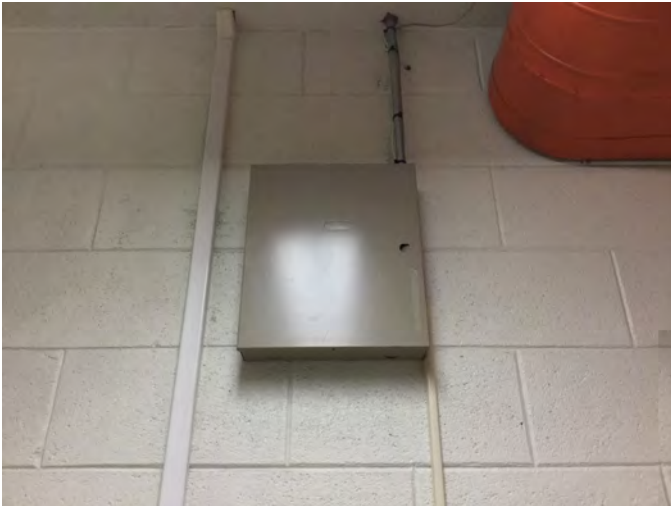
**System: D5030810 - Security & Detection Systems**

**Location:** Throughout the Building  
**Distress:** Beyond Service Life  
**Category:** Deferred Maintenance  
**Priority:** 3 - Necessary/Not Yet Critical (Years 2-5)  
**Correction:** Renew System  
**Qty:** 10,443.00  
**Unit of Measure:** S.F.  
**Estimate:** \$30,671.00  
**Assessor Name:** Eduardo Lopez  
**Date Created:** 02/06/2017

**Notes:** The security and CCTV system is beyond its expected service life and should be scheduled for replacement.

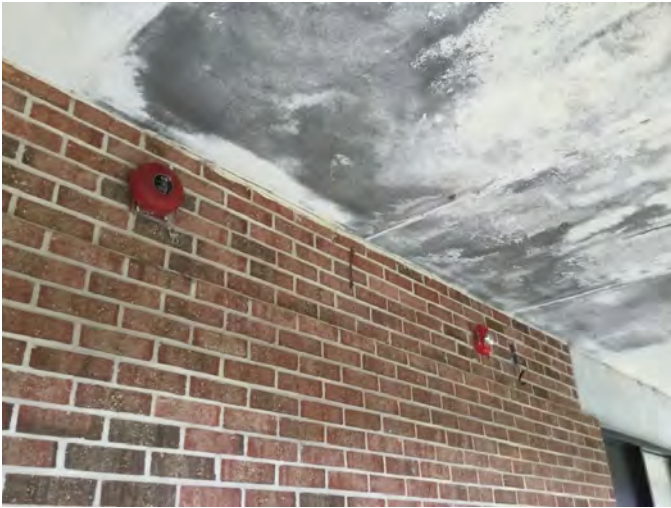
**System: D5030910 - Fire Alarm Systems**

**Location:** Throughout the Building  
**Distress:** Beyond Service Life  
**Category:** Deferred Maintenance  
**Priority:** 3 - Necessary/Not Yet Critical (Years 2-5)  
**Correction:** Renew System  
**Qty:** 10,443.00  
**Unit of Measure:** S.F.  
**Estimate:** \$55,369.00  
**Assessor Name:** Eduardo Lopez  
**Date Created:** 02/06/2017

**Notes:** The fire alarm system is beyond its expected service life and should be scheduled for replacement.

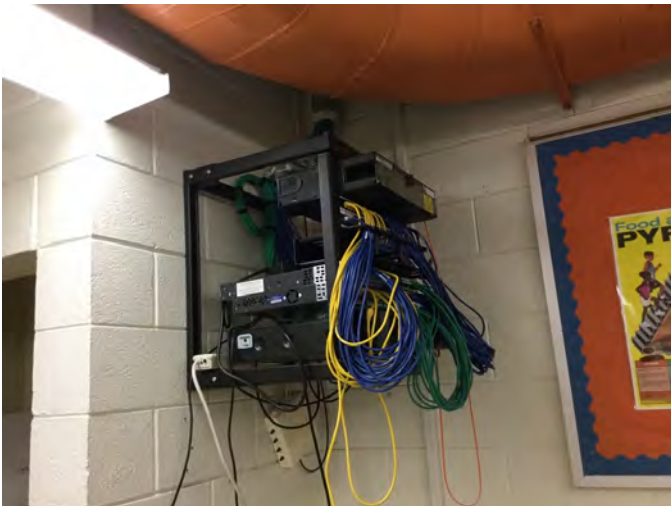
**System: D5030920 - Data Communication**

**Location:** Throughout the Building  
**Distress:** Beyond Service Life  
**Category:** Deferred Maintenance  
**Priority:** 3 - Necessary/Not Yet Critical (Years 2-5)  
**Correction:** Renew System  
**Qty:** 10,443.00  
**Unit of Measure:** S.F.  
**Estimate:** \$71,681.00  
**Assessor Name:** Eduardo Lopez  
**Date Created:** 02/06/2017

**Notes:** The data communication system is beyond its expected service life and should be scheduled for replacement.

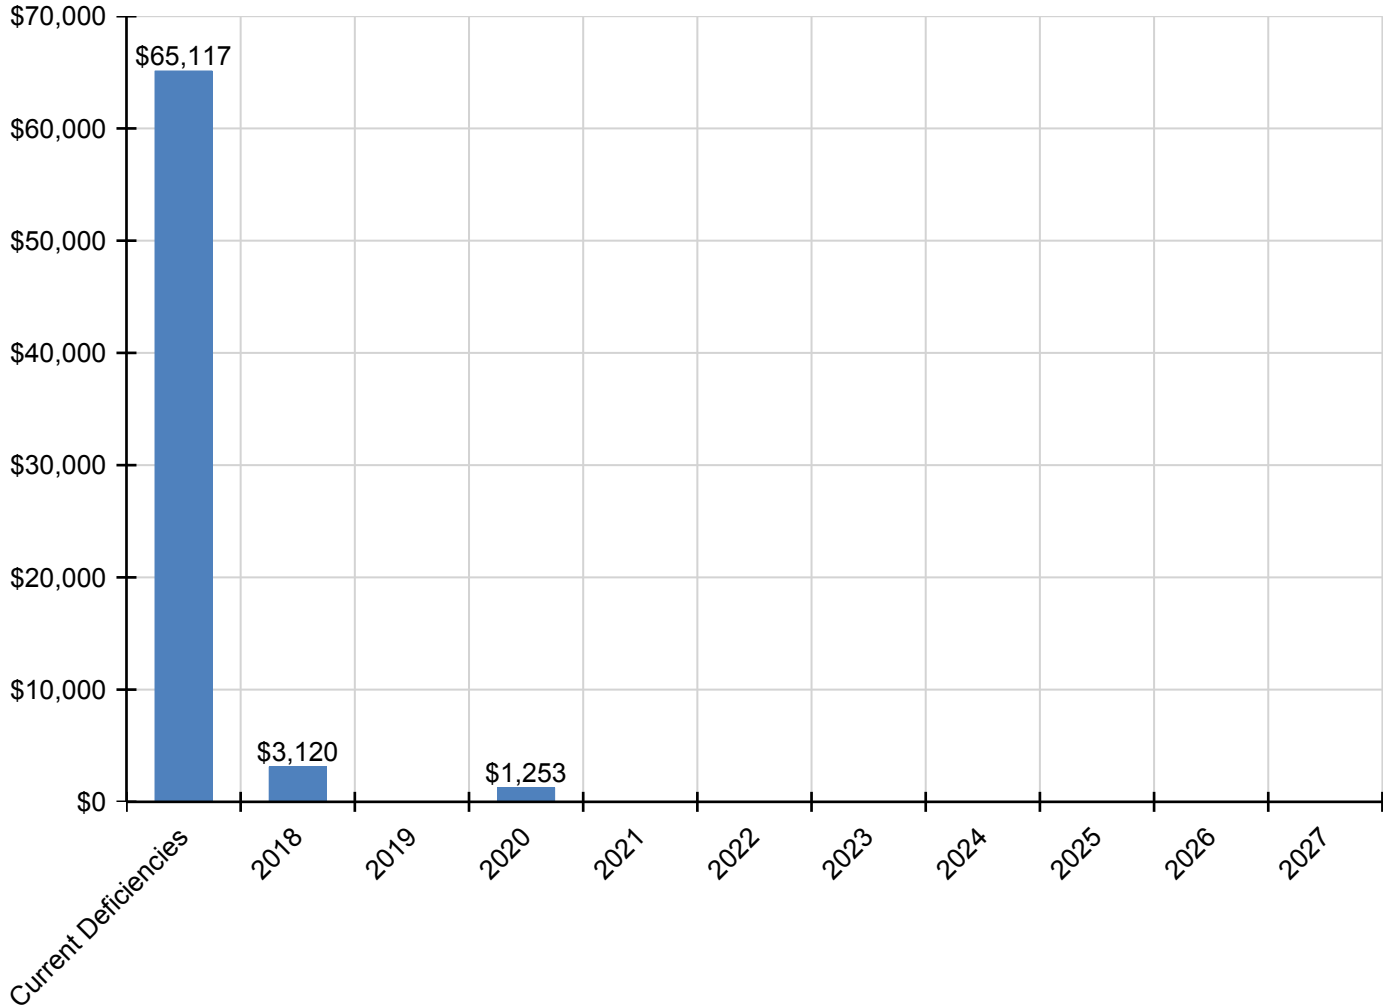
## Forecasted Capital Renewal Requirement

The following chart shows the current building deficiencies and forecasting capital renewal or sustainment requirements over the next ten years.

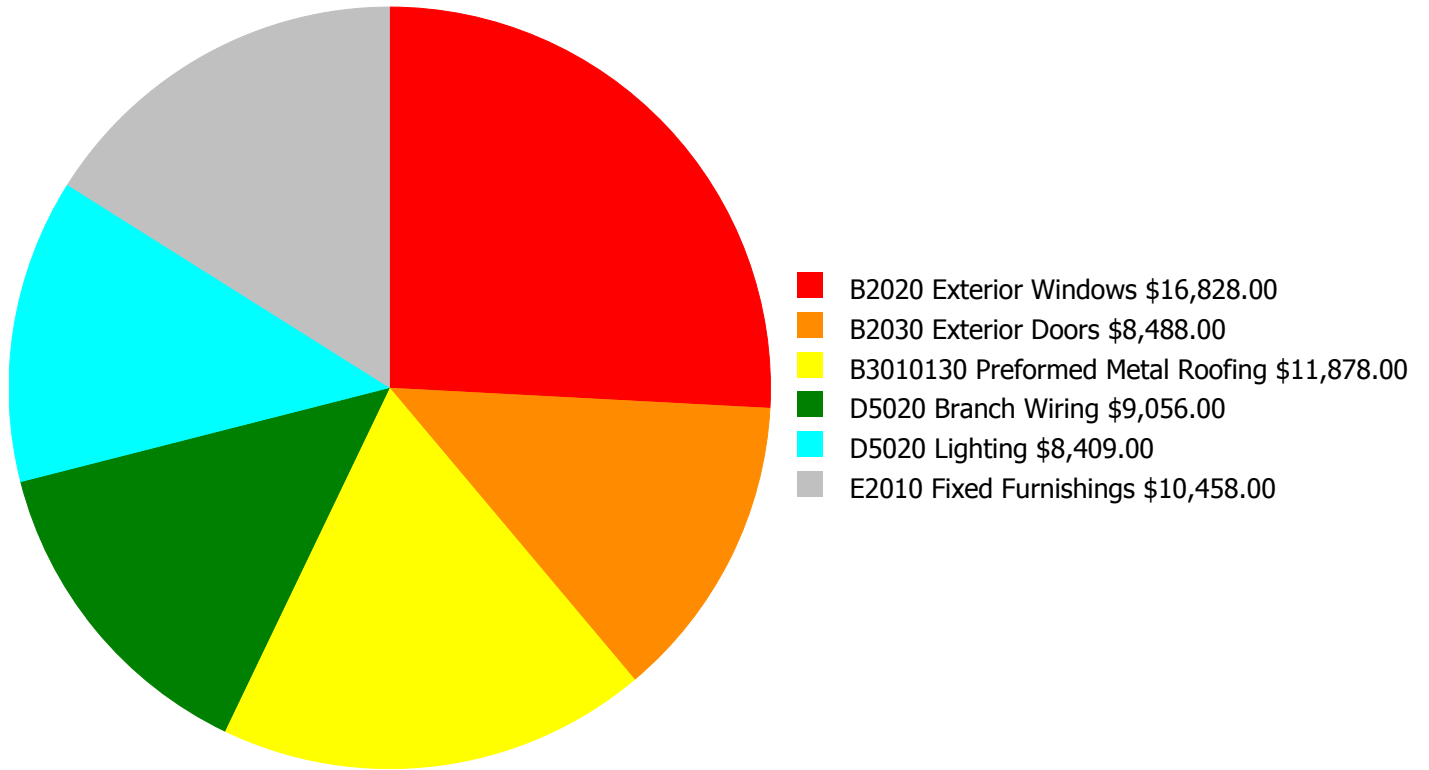
## Deficiency Summary by System

Current deficiencies included assemblies that have reached or exceeded their design life or components of the assemblies that are in need of repair. Assemblies that have reached their design life are identified as current deficiencies and assigned the distress 'Beyond Useful Life'. The following chart lists all current deficiencies associated with this facility.

**Budget Estimate Total: \$65,117.00**

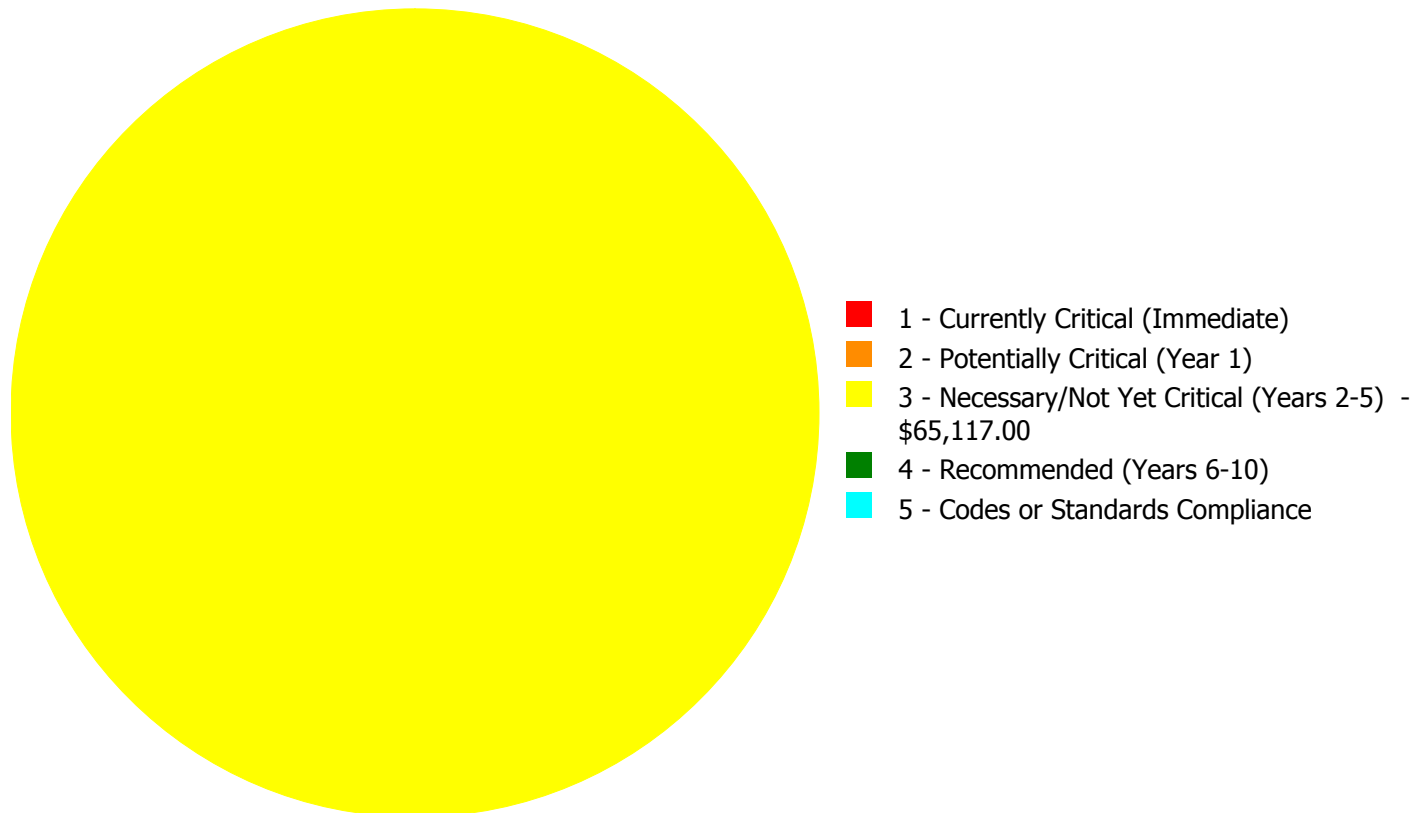
## Deficiency Summary by Priority

The following chart shows the total repair costs broken down by priority. Assessors assigned deficiencies within eCOMET to one of the following priority categories:

**Budget Estimate Total: \$65,117.00**

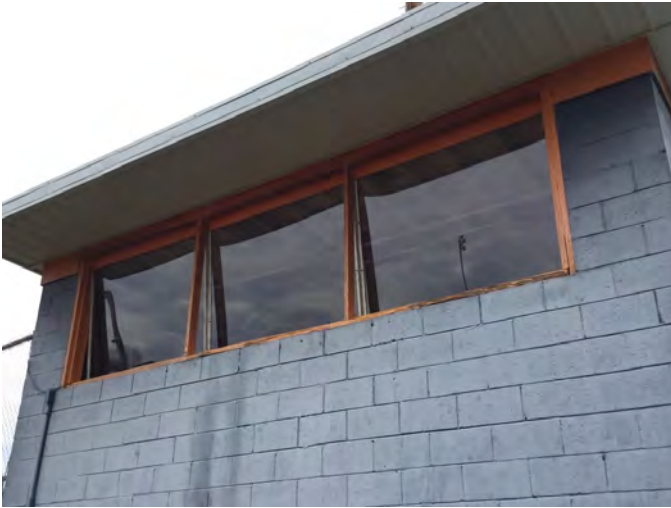
#### System: B2020 - Exterior Windows

**Location:** Exterior Walls  
**Distress:** Beyond Service Life  
**Category:** Deferred Maintenance  
**Priority:** 3 - Necessary/Not Yet Critical (Years 2-5)  
**Correction:** Renew System  
**Qty:** 891.00  
**Unit of Measure:** S.F.  
**Estimate:** \$16,828.00  
**Assessor Name:** Eduardo Lopez  
**Date Created:** 01/12/2017

**Notes:** The exterior windows are aged, rusted, not energy efficient and should be replaced.

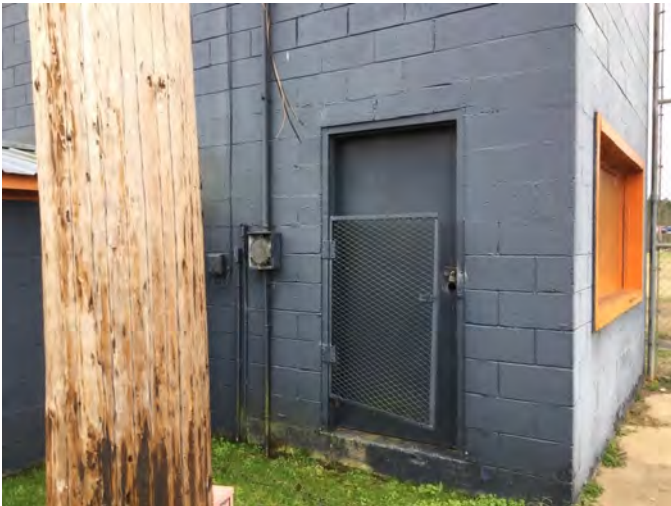
#### System: B2030 - Exterior Doors

**Location:** Exterior Walls  
**Distress:** Beyond Service Life  
**Category:** Deferred Maintenance  
**Priority:** 3 - Necessary/Not Yet Critical (Years 2-5)  
**Correction:** Renew System  
**Qty:** 891.00  
**Unit of Measure:** S.F.  
**Estimate:** \$8,488.00  
**Assessor Name:** Eduardo Lopez  
**Date Created:** 01/12/2017

**Notes:** The exterior doors are aged, rusted and should be replaced.

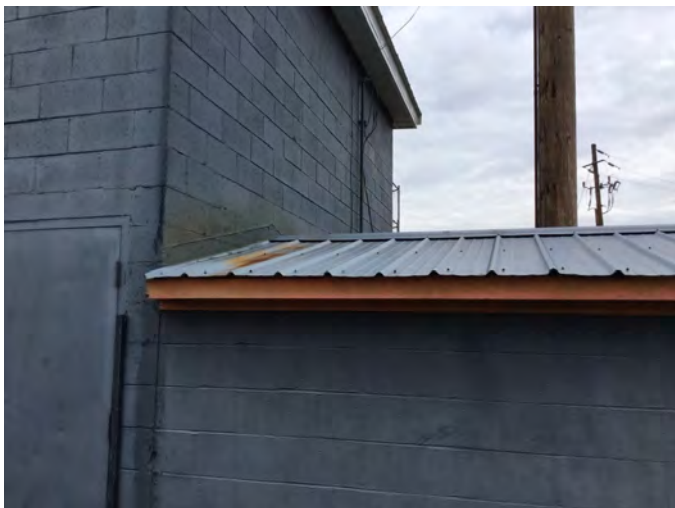
**System: B3010130 - Preformed Metal Roofing**

**Location:** Roof  
**Distress:** Beyond Service Life  
**Category:** Deferred Maintenance  
**Priority:** 3 - Necessary/Not Yet Critical (Years 2-5)  
**Correction:** Renew System  
**Qty:** 891.00  
**Unit of Measure:** S.F.  
**Estimate:** \$11,878.00  
**Assessor Name:** Eduardo Lopez  
**Date Created:** 01/12/2017

**Notes:** The metal roof covering is aged, showing signs of failure and should be replaced.

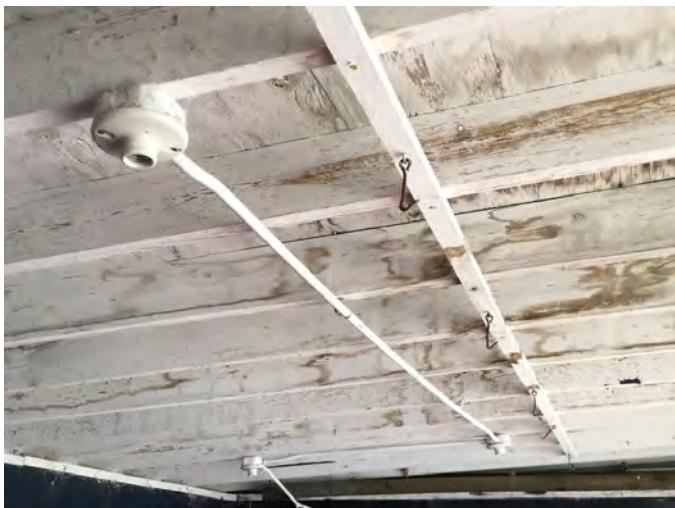
**System: D5020 - Branch Wiring**

**Location:** Throughout the Building  
**Distress:** Beyond Service Life  
**Category:** Deferred Maintenance  
**Priority:** 3 - Necessary/Not Yet Critical (Years 2-5)  
**Correction:** Renew System  
**Qty:** 891.00  
**Unit of Measure:** S.F.  
**Estimate:** \$9,056.00  
**Assessor Name:** Eduardo Lopez  
**Date Created:** 01/12/2017

**Notes:** The original branch wiring system is operating but is aged, in marginal condition, and should be replaced.

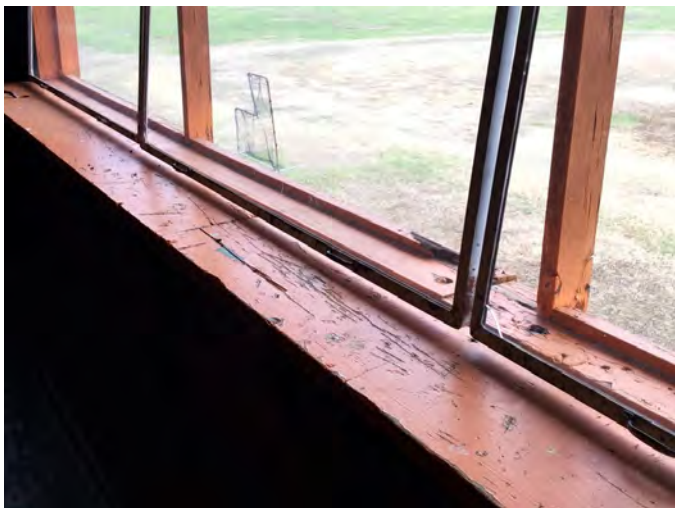
**System: E2010 - Fixed Furnishings**

**Location:** Throughout the Building  
**Distress:** Beyond Service Life  
**Category:** Deferred Maintenance  
**Priority:** 3 - Necessary/Not Yet Critical (Years 2-5)  
**Correction:** Renew System  
**Qty:** 891.00  
**Unit of Measure:** S.F.  
**Estimate:** \$10,458.00  
**Assessor Name:** Eduardo Lopez  
**Date Created:** 01/12/2017

**Notes:** The fixed furnishings are aged, in marginal condition, and should be replaced.
