# Anson Middle

## Campus Assessment Report

March 7, 2017

## Campus Assessment Report - 1966 Building, Cafe/Gym

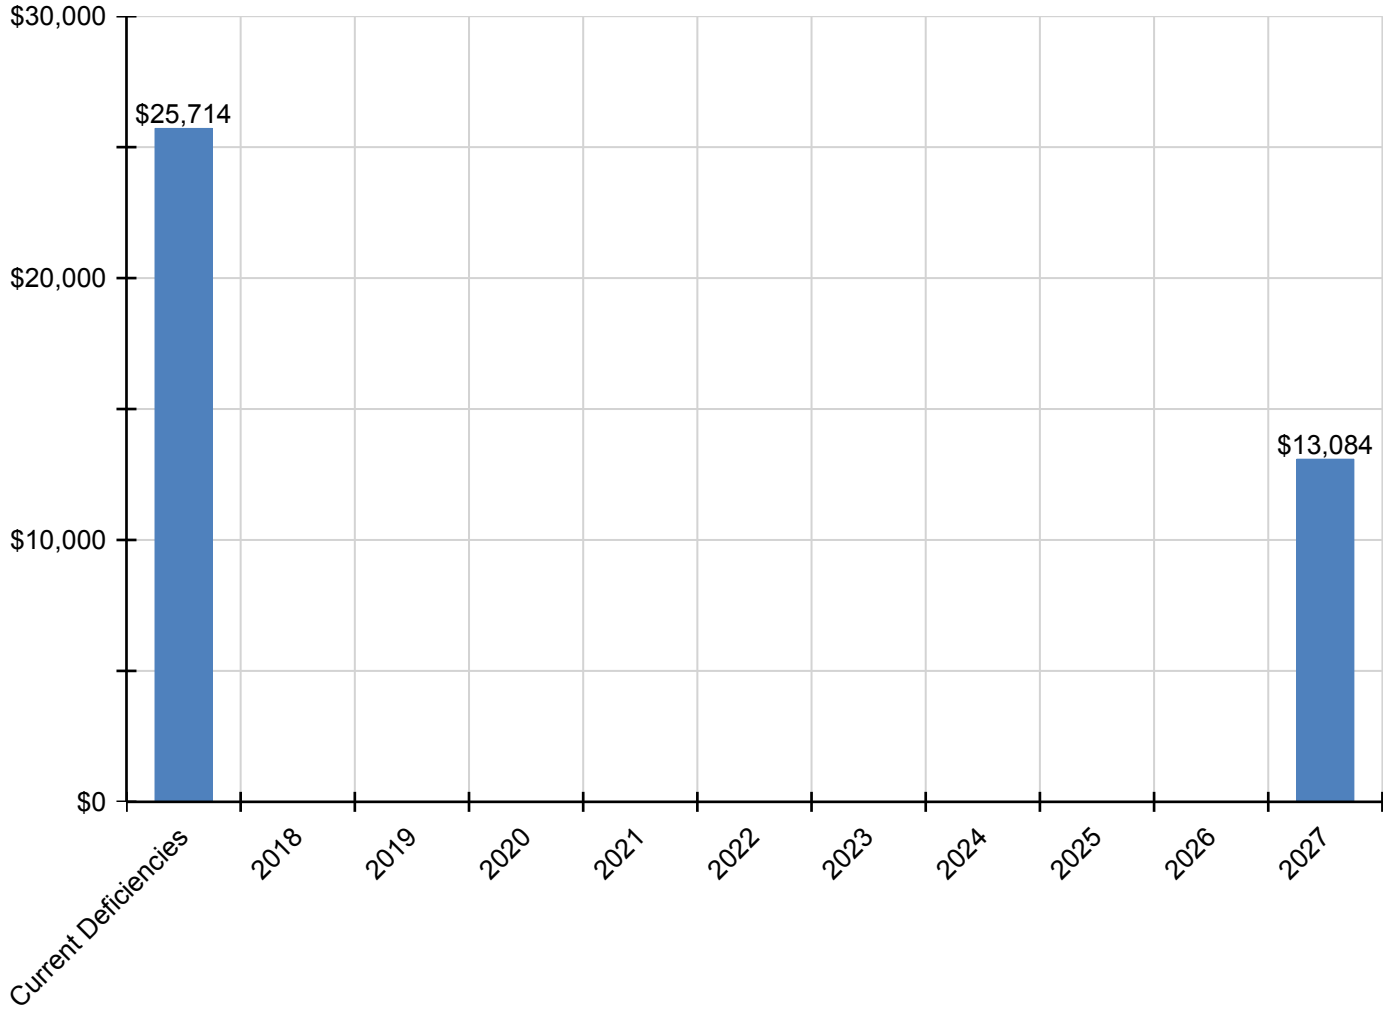
## Forecasted Capital Renewal Requirement

The following chart shows the current building deficiencies and forecasting capital renewal or sustainment requirements over the next ten years.

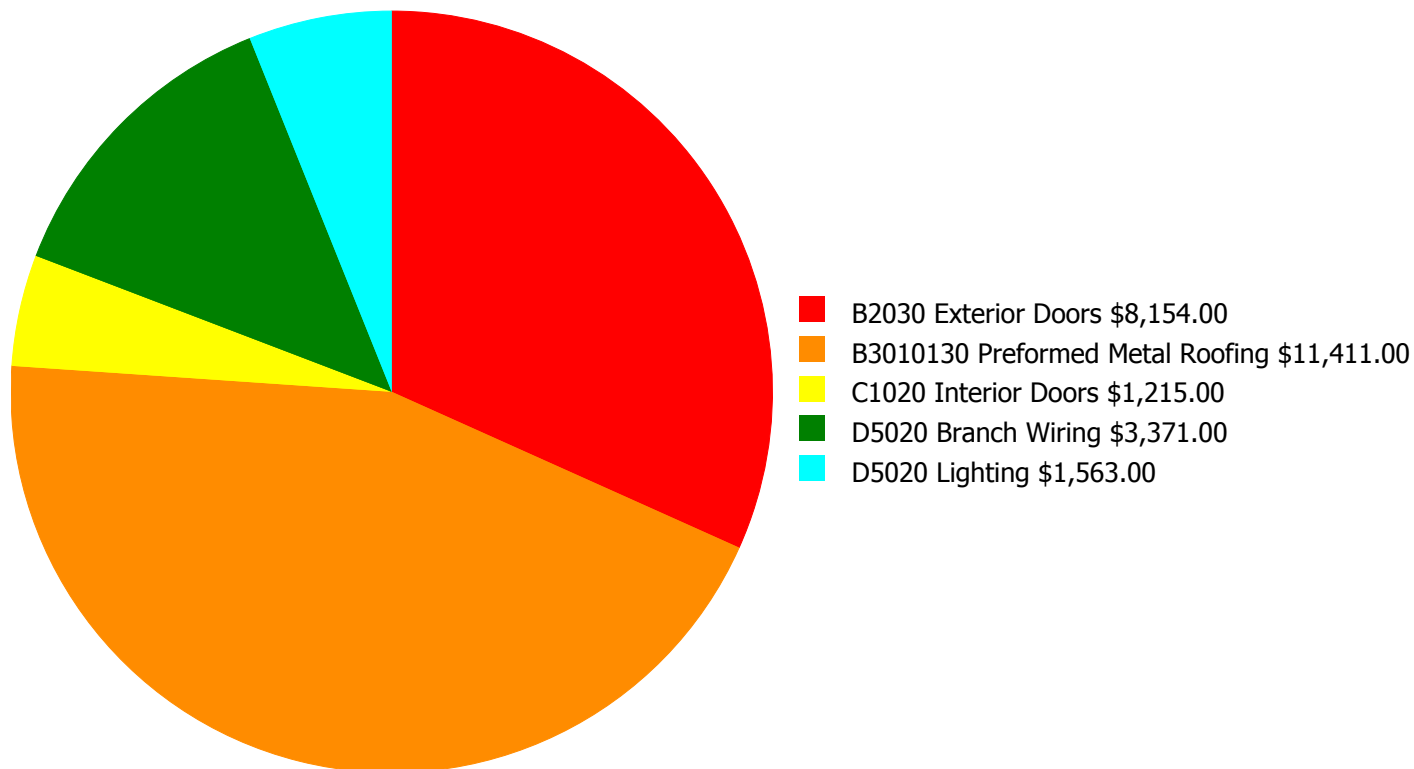
## Deficiency Summary by System

Current deficiencies included assemblies that have reached or exceeded their design life or components of the assemblies that are in need of repair. Assemblies that have reached their design life are identified as current deficiencies and assigned the distress 'Beyond Useful Life'. The following chart lists all current deficiencies associated with this facility.

**Budget Estimate Total: \$25,714.00**

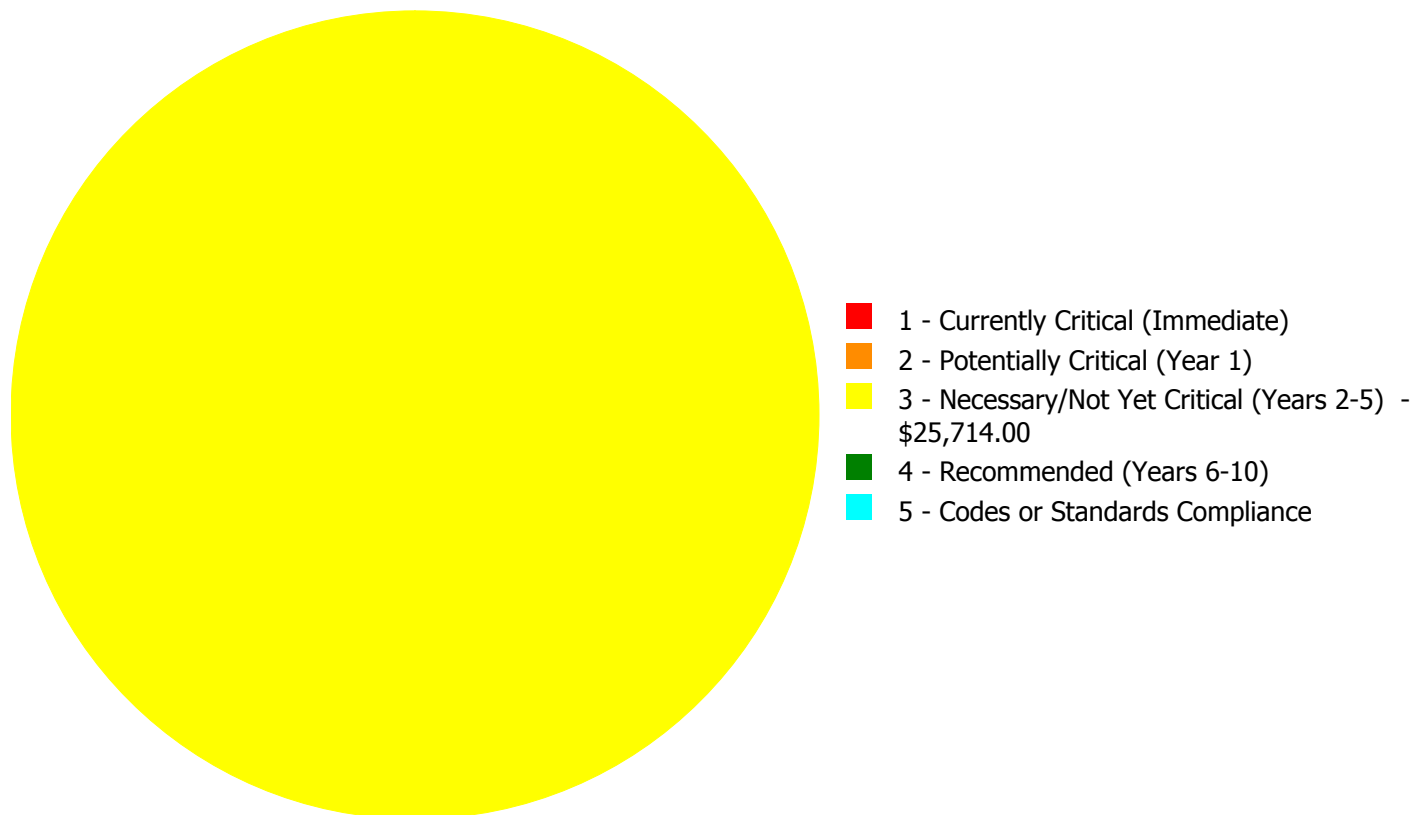
The following chart shows the total repair costs broken down by priority. Assessors assigned deficiencies within eCOMET to one of the following priority categories:

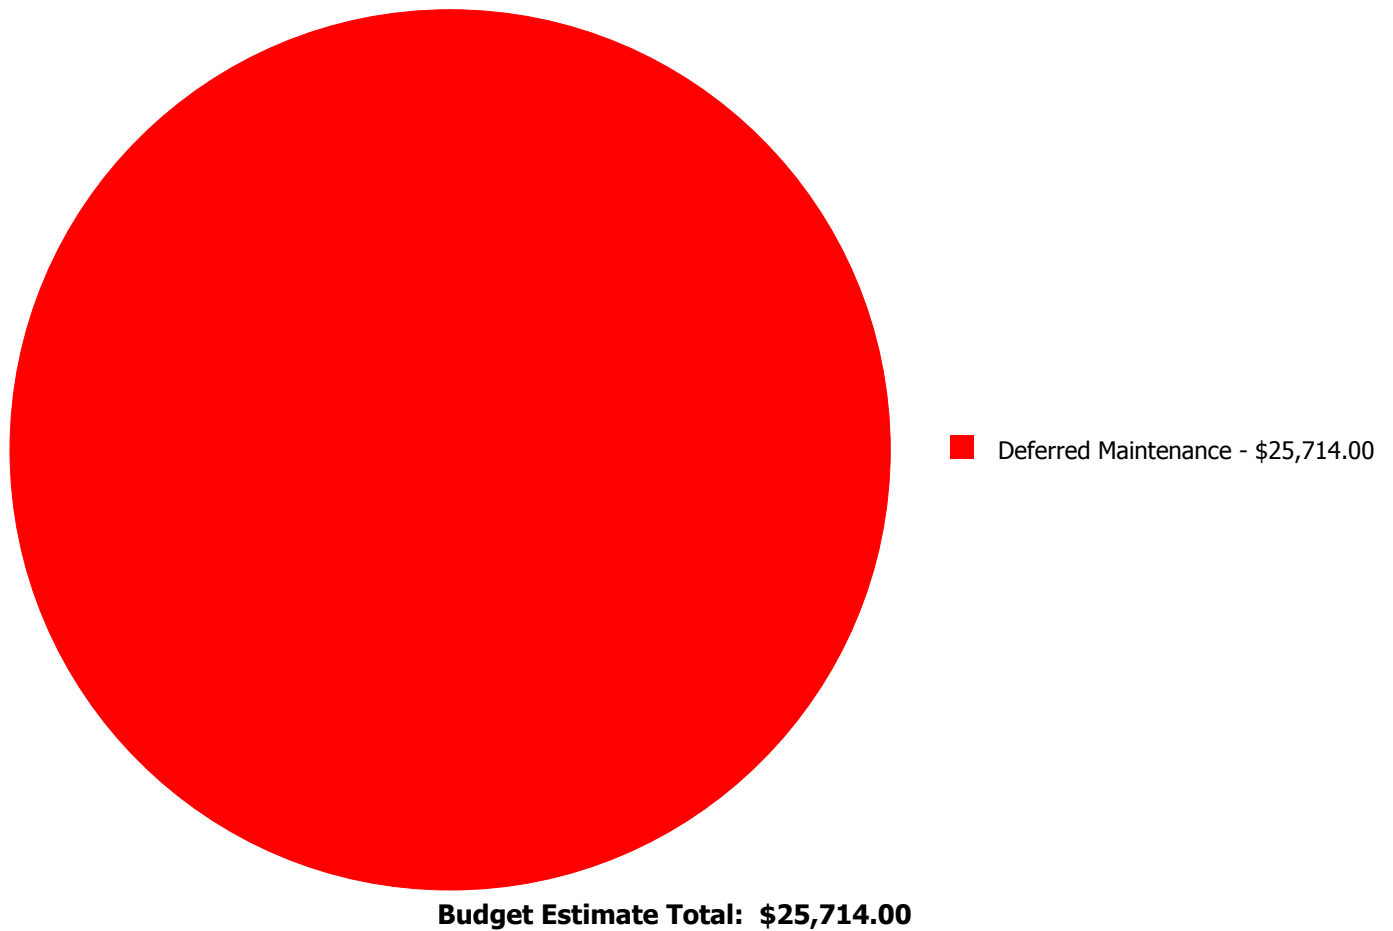
The following chart shows the total repair costs broken down by deficiency categories. Assessors assigned deficiencies to one of the following categories:

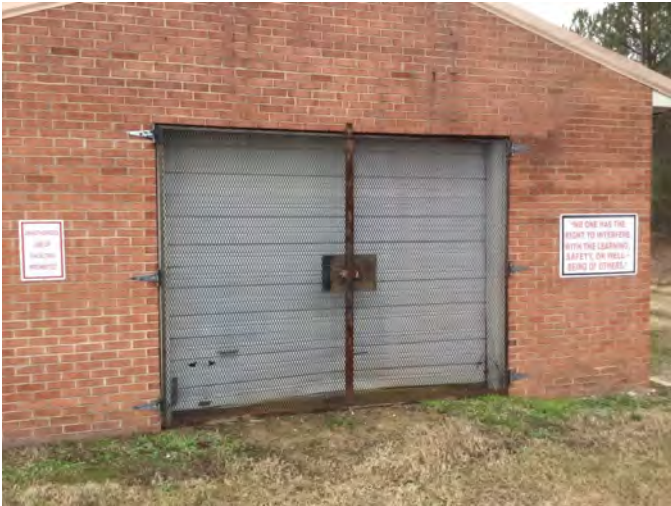
**System: B2030 - Exterior Doors**

**Location:** Exterior Walls  
**Distress:** Beyond Service Life  
**Category:** Deferred Maintenance  
**Priority:** 3 - Necessary/Not Yet Critical (Years 2-5)  
**Correction:** Renew System  
**Qty:** 856.00  
**Unit of Measure:** S.F.  
**Estimate:** \$8,154.00  
**Assessor Name:** Eduardo Lopez  
**Date Created:** 01/12/2017

**Notes:** The exterior doors are aged, rusted and should be replaced.

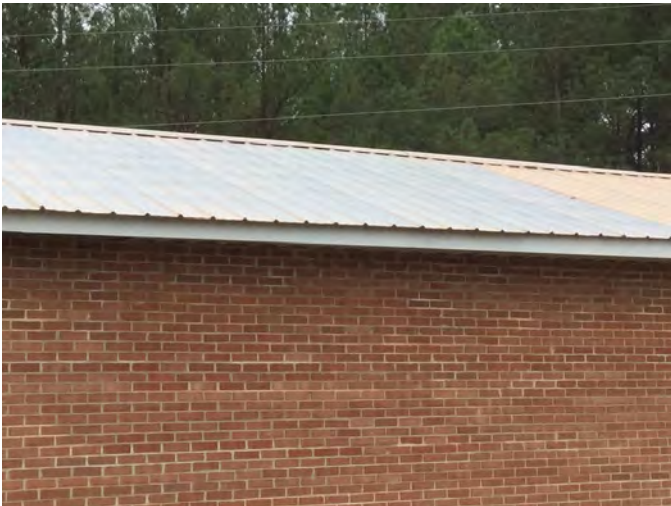
**System: B3010130 - Preformed Metal Roofing**

**Location:** Roof  
**Distress:** Beyond Service Life  
**Category:** Deferred Maintenance  
**Priority:** 3 - Necessary/Not Yet Critical (Years 2-5)  
**Correction:** Renew System  
**Qty:** 856.00  
**Unit of Measure:** S.F.  
**Estimate:** \$11,411.00  
**Assessor Name:** Eduardo Lopez  
**Date Created:** 01/12/2017

**Notes:** The metal roof covering is aged, showing signs of failure and should be replaced.

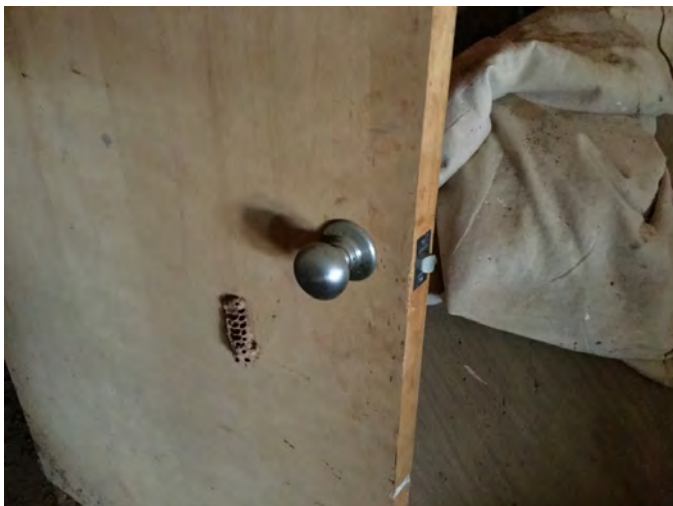
**System: C1020 - Interior Doors**

**Location:** Throughout the Building  
**Distress:** Beyond Service Life  
**Category:** Deferred Maintenance  
**Priority:** 3 - Necessary/Not Yet Critical (Years 2-5)  
**Correction:** Renew System  
**Qty:** 856.00  
**Unit of Measure:** S.F.  
**Estimate:** \$1,215.00  
**Assessor Name:** Eduardo Lopez  
**Date Created:** 01/12/2017

**Notes:** The interior doors are aged, failing, most hardware is not ADA or code compliant and should be replaced.

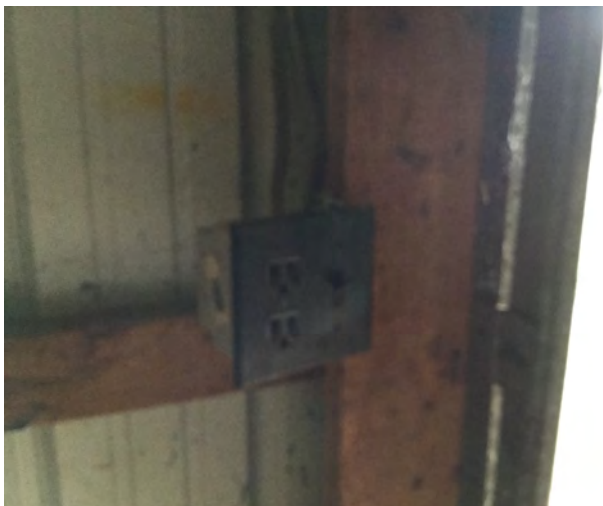
**System: D5020 - Branch Wiring**

**Location:** Throughout the Building  
**Distress:** Beyond Service Life  
**Category:** Deferred Maintenance  
**Priority:** 3 - Necessary/Not Yet Critical (Years 2-5)  
**Correction:** Renew System  
**Qty:** 856.00  
**Unit of Measure:** S.F.  
**Estimate:** \$3,371.00  
**Assessor Name:** Eduardo Lopez  
**Date Created:** 01/12/2017

**Notes:** The original branch wiring system is operating but is aged, in marginal condition, and should be replaced.

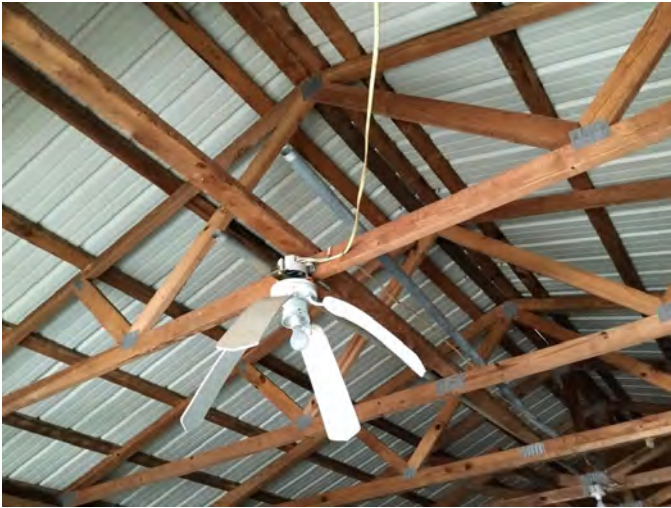
**System: D5020 - Lighting**

**Location:** Throughout the Building  
**Distress:** Beyond Service Life  
**Category:** Deferred Maintenance  
**Priority:** 3 - Necessary/Not Yet Critical (Years 2-5)  
**Correction:** Renew System  
**Qty:** 856.00  
**Unit of Measure:** S.F.  
**Estimate:** \$1,563.00  
**Assessor Name:** Eduardo Lopez  
**Date Created:** 01/12/2017

**Notes:** The original branch wiring system is operating but is aged, in marginal condition, and should be replaced.

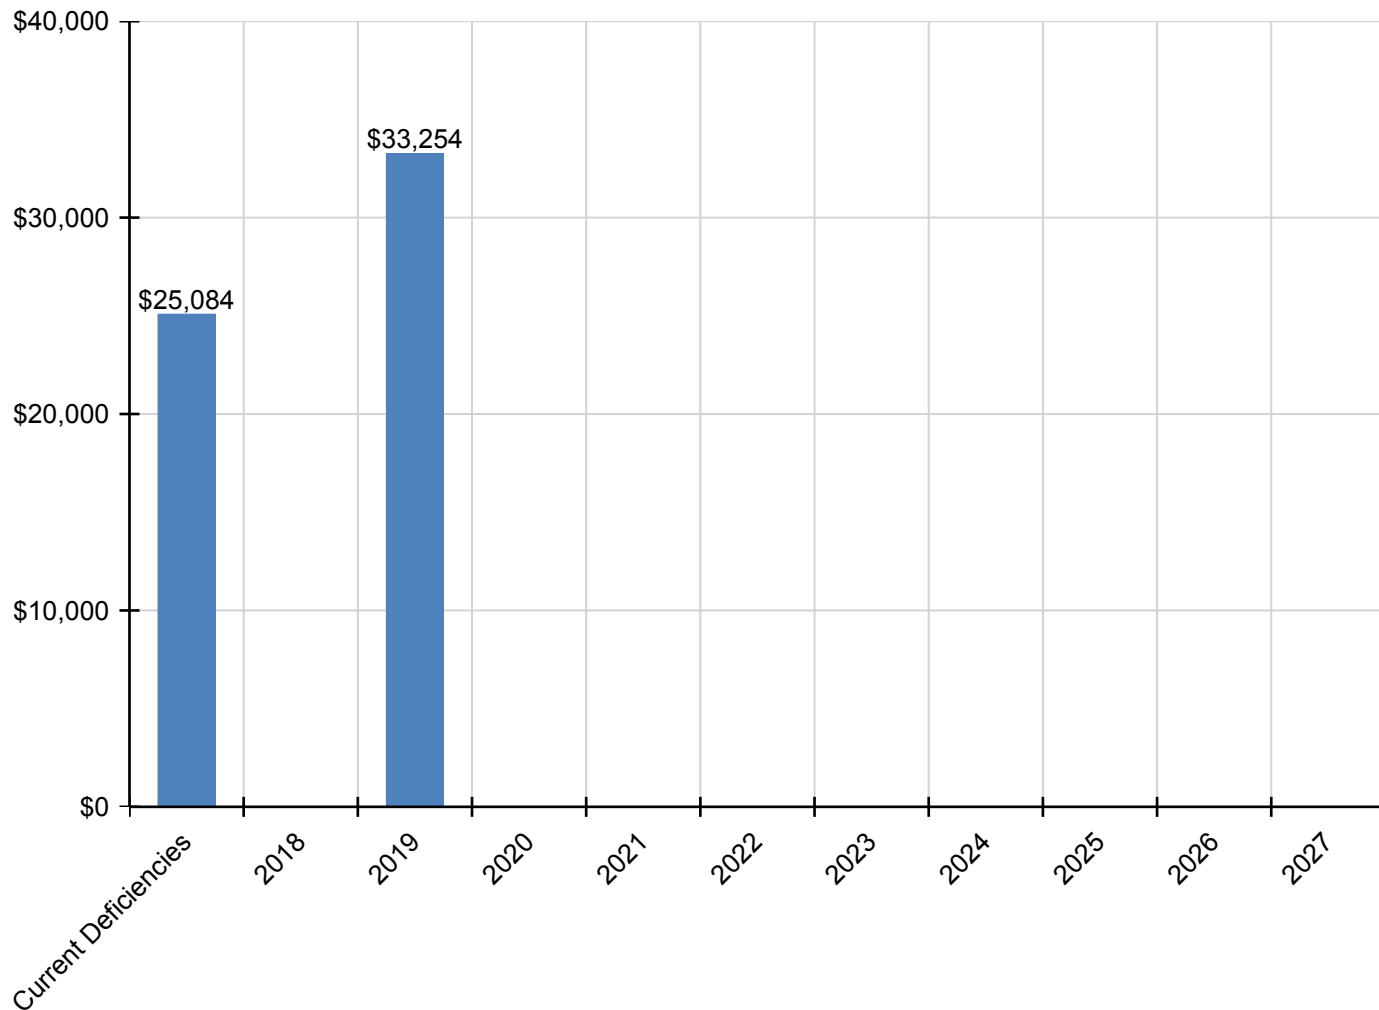
### Forecasted Capital Renewal Requirement

The following chart shows the current building deficiencies and forecasting capital renewal or sustainment requirements over the next ten years.

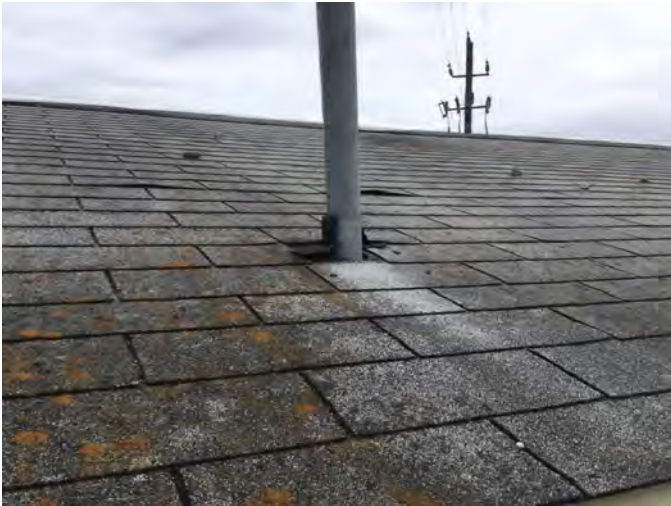
**System: B3010140 - Asphalt Shingles**

**Location:** Roof  
**Distress:** Beyond Service Life  
**Category:** Deferred Maintenance  
**Priority:** 3 - Necessary/Not Yet Critical (Years 2-5)  
**Correction:** Renew System  
**Qty:** 800.00  
**Unit of Measure:** S.F.  
**Estimate:** \$5,046.00  
**Assessor Name:** Eduardo Lopez  
**Date Created:** 01/12/2017

**Notes:** The asphalt shingles roof covering is aged, showing signs of failure and should be replaced.

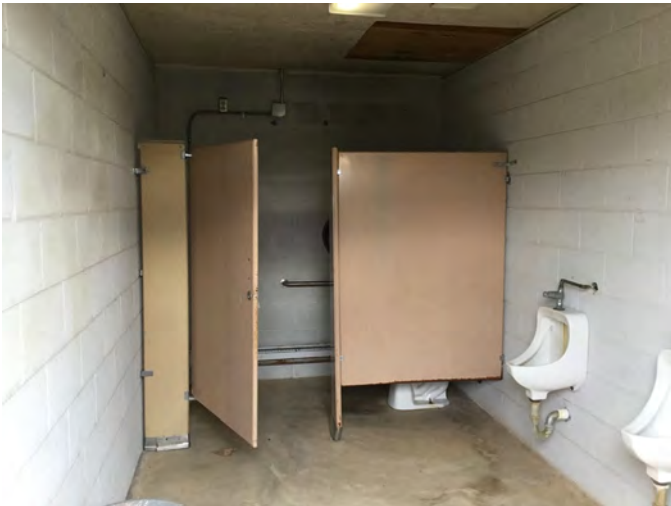
**System: C1030 - Fittings**

**Location:** Throughout the Building  
**Distress:** Beyond Service Life  
**Category:** Deferred Maintenance  
**Priority:** 3 - Necessary/Not Yet Critical (Years 2-5)  
**Correction:** Renew System  
**Qty:** 800.00  
**Unit of Measure:** S.F.  
**Estimate:** \$9,812.00  
**Assessor Name:** Eduardo Lopez  
**Date Created:** 01/12/2017

**Notes:** The fittings throughout the building are aged, in marginal condition, handrails and room signage are not ADA compliant and should be replaced.

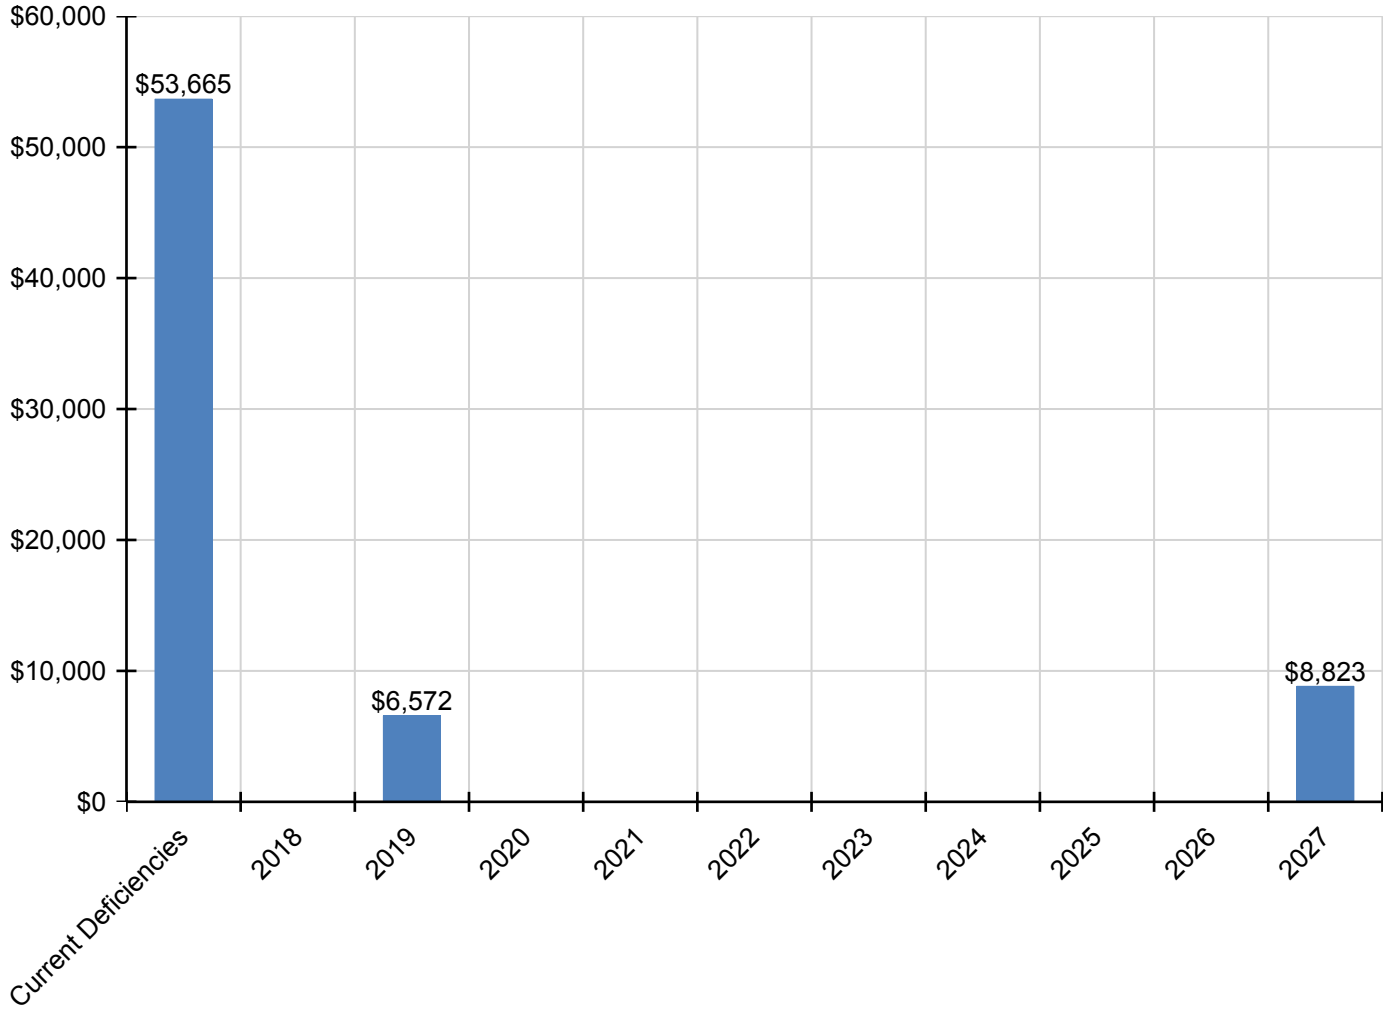
## Forecasted Capital Renewal Requirement

The following chart shows the current building deficiencies and forecasting capital renewal or sustainment requirements over the next ten years.

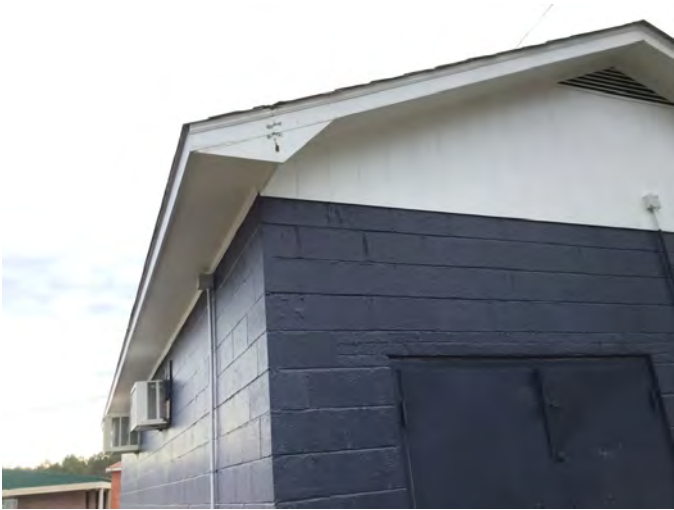
#### System: B3010140 - Asphalt Shingles

**Location:** Roof  
**Distress:** Beyond Service Life  
**Category:** Deferred Maintenance  
**Priority:** 3 - Necessary/Not Yet Critical (Years 2-5)  
**Correction:** Renew System  
**Qty:** 800.00  
**Unit of Measure:** S.F.  
**Estimate:** \$5,046.00  
**Assessor Name:** Eduardo Lopez  
**Date Created:** 01/12/2017

**Notes:** The asphalt shingles roof covering is aged, showing signs of failure and should be replaced.

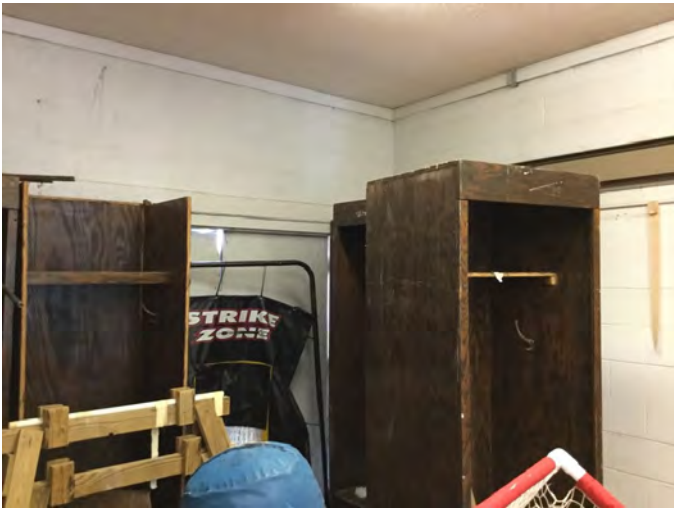
#### System: C3010 - Wall Finishes

**Location:** Throughout the Building  
**Distress:** Beyond Service Life  
**Category:** Deferred Maintenance  
**Priority:** 3 - Necessary/Not Yet Critical (Years 2-5)  
**Correction:** Renew System  
**Qty:** 800.00  
**Unit of Measure:** S.F.  
**Estimate:** \$6,565.00  
**Assessor Name:** Eduardo Lopez  
**Date Created:** 01/12/2017

**Notes:** The wall finishes are aged, scuffed, fading, stained and should be replaced.

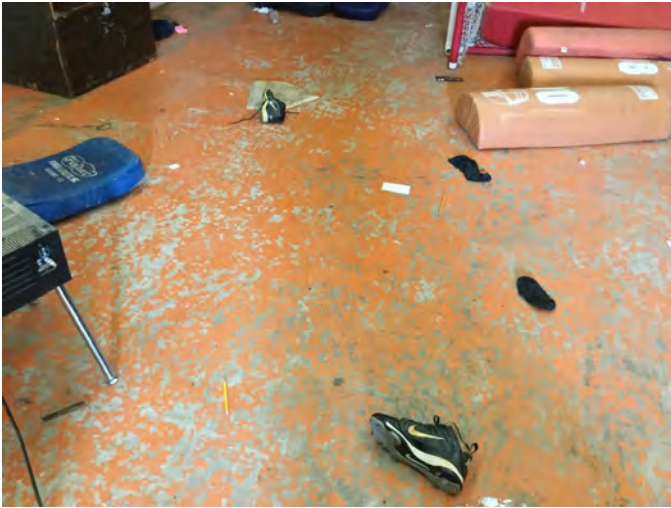
**System: C3020 - Floor Finishes**

**Location:** Throughout the Building  
**Distress:** Beyond Service Life  
**Category:** Deferred Maintenance  
**Priority:** 3 - Necessary/Not Yet Critical (Years 2-5)  
**Correction:** Renew System  
**Qty:** 800.00  
**Unit of Measure:** S.F.  
**Estimate:** \$11,211.00  
**Assessor Name:** Eduardo Lopez  
**Date Created:** 01/12/2017

**Notes:** The original flooring is in poor conditions and should be replaced.

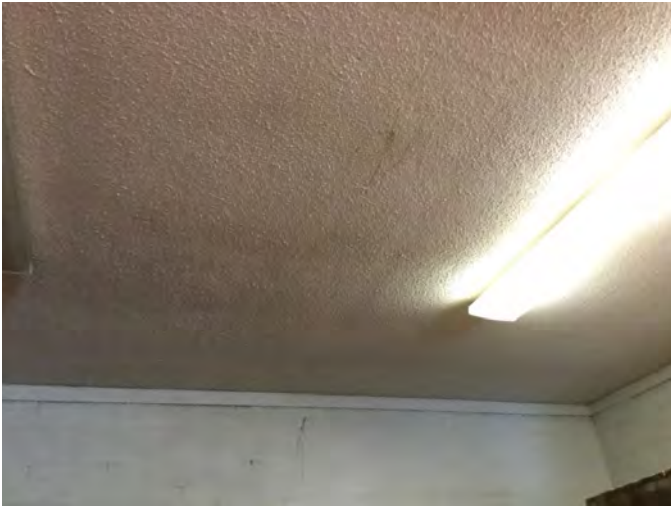
**System: C3030 - Ceiling Finishes**

**Location:** Throughout the Building  
**Distress:** Beyond Service Life  
**Category:** Deferred Maintenance  
**Priority:** 3 - Necessary/Not Yet Critical (Years 2-5)  
**Correction:** Renew System  
**Qty:** 800.00  
**Unit of Measure:** S.F.  
**Estimate:** \$8,386.00  
**Assessor Name:** Eduardo Lopez  
**Date Created:** 01/12/2017

**Notes:** The original ceiling finishes are aged, failing and should be replaced.

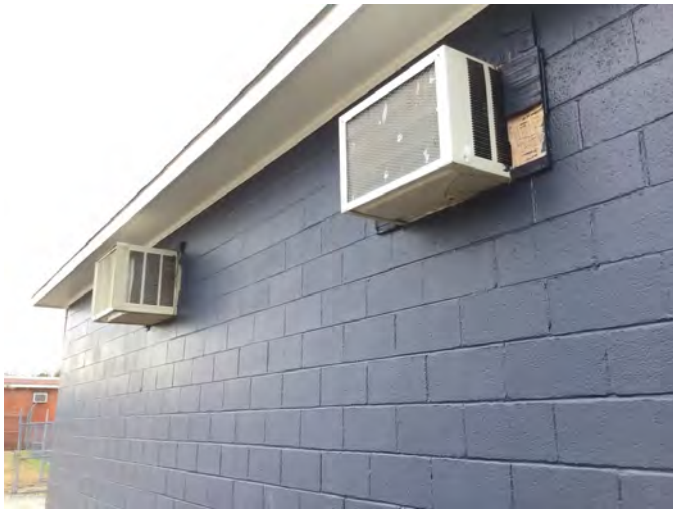
**System: D3050 - Terminal & Package Units**

**Location:** Throughout the Building  
**Distress:** Beyond Service Life  
**Category:** Deferred Maintenance  
**Priority:** 3 - Necessary/Not Yet Critical (Years 2-5)  
**Correction:** Renew System  
**Qty:** 800.00  
**Unit of Measure:** S.F.  
**Estimate:** \$14,925.00  
**Assessor Name:** Eduardo Lopez  
**Date Created:** 01/12/2017

**Notes:** Terminal and package units are beyond their expected service life and should be scheduled for replacement.

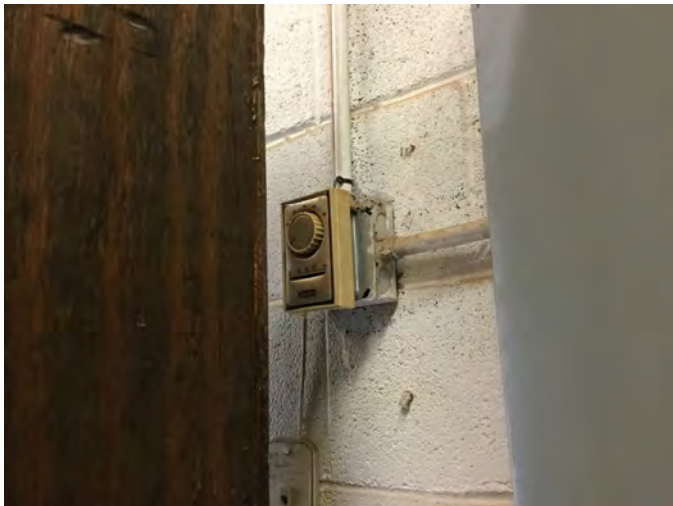
**System: D3060 - Controls & Instrumentation**

**Location:** Throughout the Building  
**Distress:** Beyond Service Life  
**Category:** Deferred Maintenance  
**Priority:** 3 - Necessary/Not Yet Critical (Years 2-5)  
**Correction:** Renew System  
**Qty:** 800.00  
**Unit of Measure:** S.F.  
**Estimate:** \$3,062.00  
**Assessor Name:** Eduardo Lopez  
**Date Created:** 01/12/2017

**Notes:** The controls and instrumentation system is in marginal condition and should be schedule for replacement.

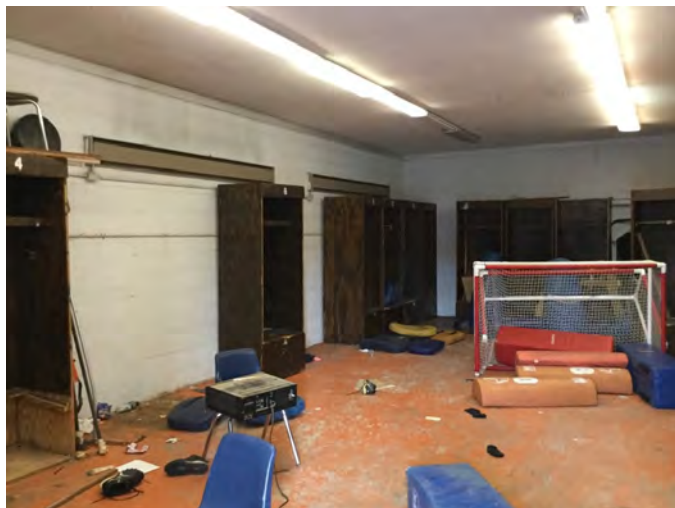
**System: E2010 - Fixed Furnishings**

**Location:** Throughout the Building  
**Distress:** Beyond Service Life  
**Category:** Deferred Maintenance  
**Priority:** 3 - Necessary/Not Yet Critical (Years 2-5)  
**Correction:** Renew System  
**Qty:** 800.00  
**Unit of Measure:** S.F.  
**Estimate:** \$4,470.00  
**Assessor Name:** Eduardo Lopez  
**Date Created:** 01/12/2017

**Notes:** The fixed furnishings are aged, in marginal condition, and should be replaced.

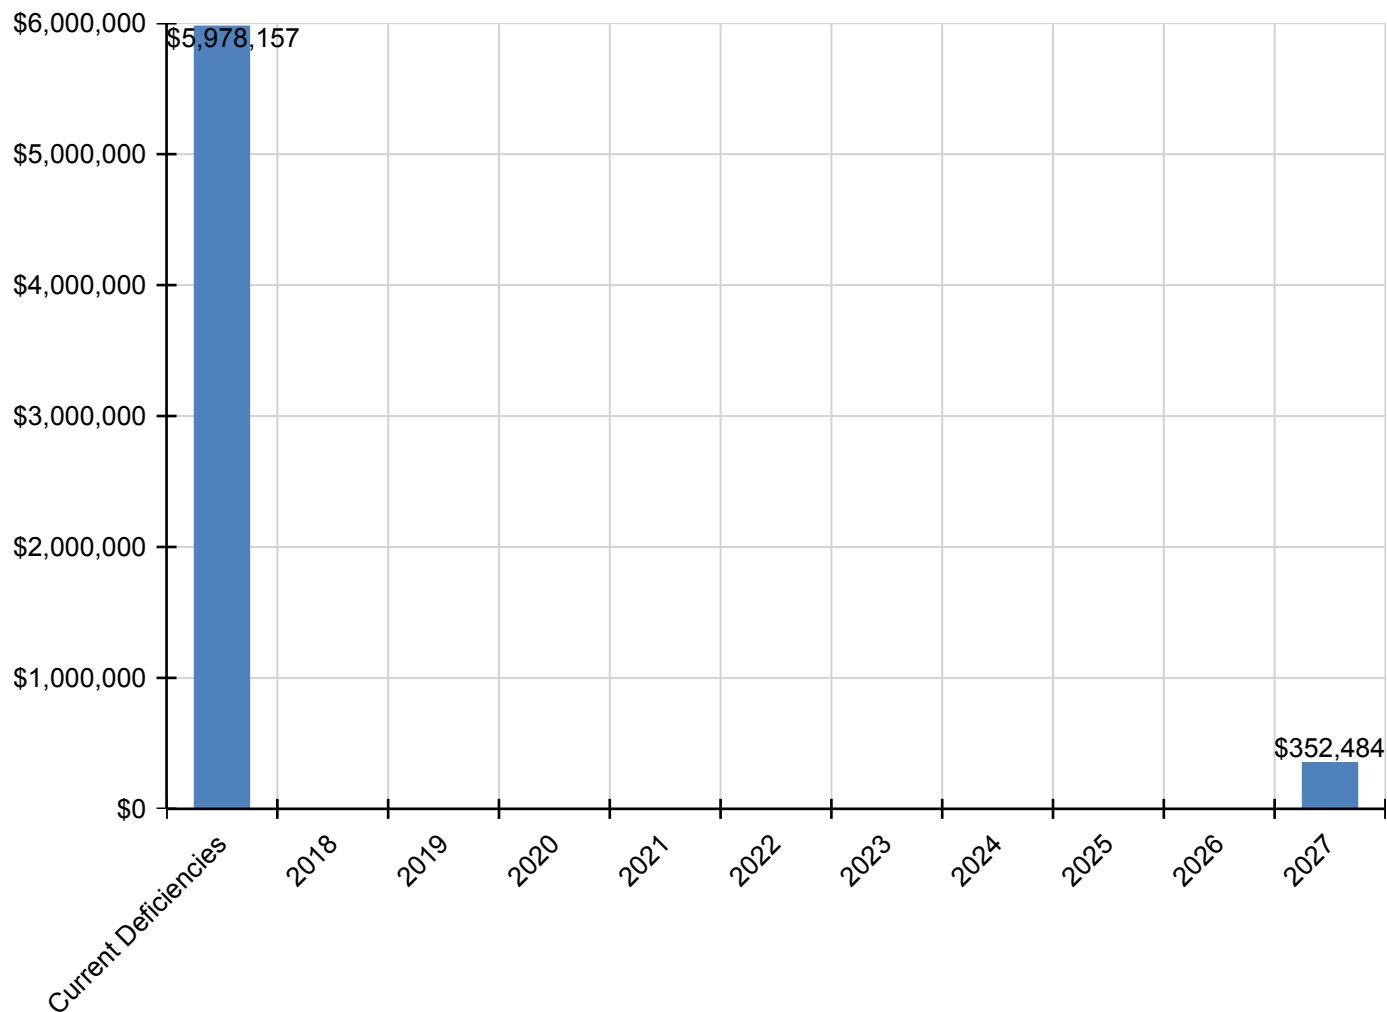
## Forecasted Capital Renewal Requirement

The following chart shows the current building deficiencies and forecasting capital renewal or sustainment requirements over the next ten years.

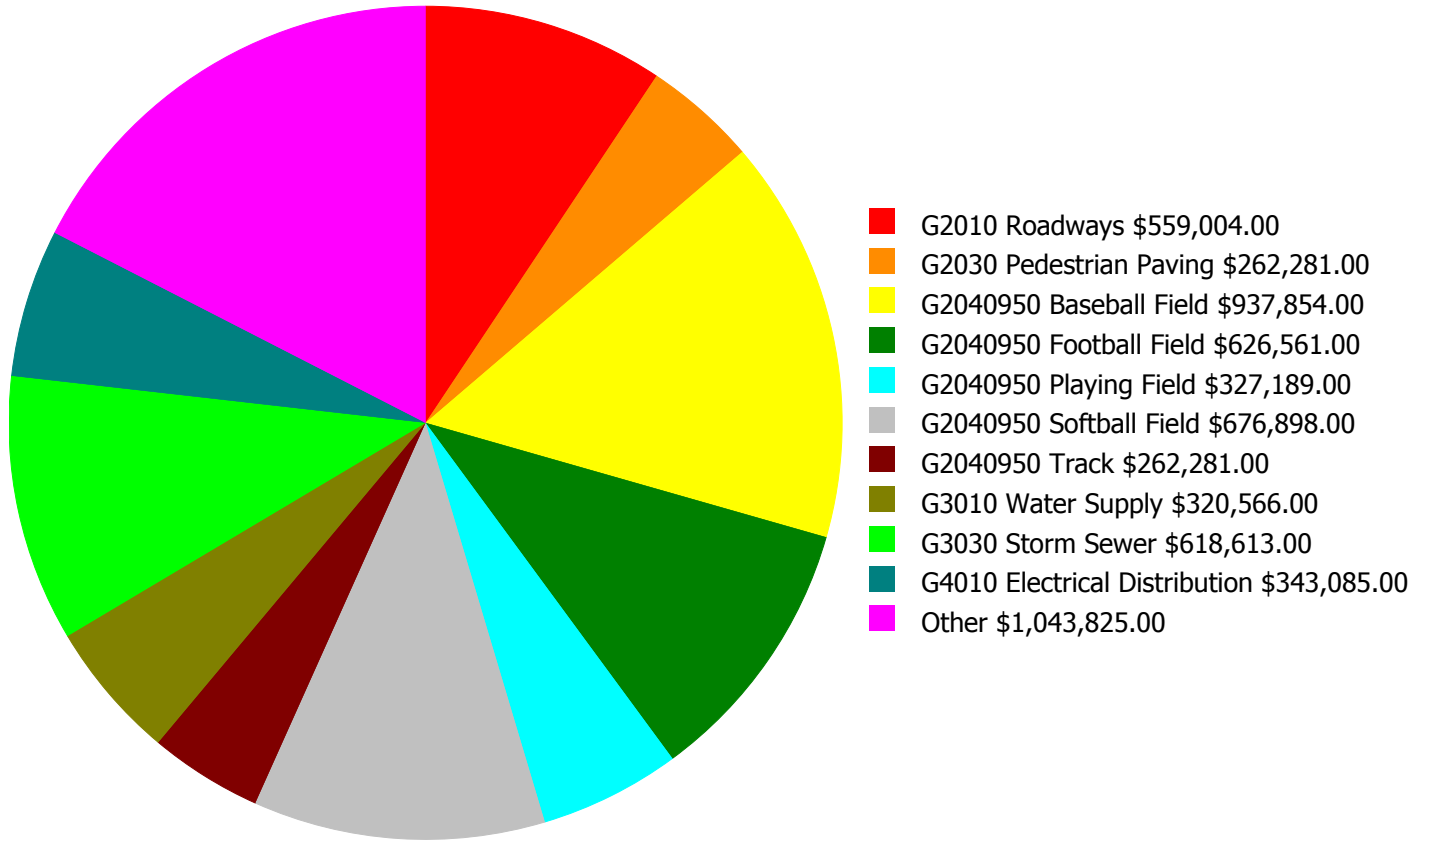
## Deficiency Summary by System

Current deficiencies included assemblies that have reached or exceeded their design life or components of the assemblies that are in need of repair. Assemblies that have reached their design life are identified as current deficiencies and assigned the distress 'Beyond Useful Life'. The following chart lists all current deficiencies associated with this facility.

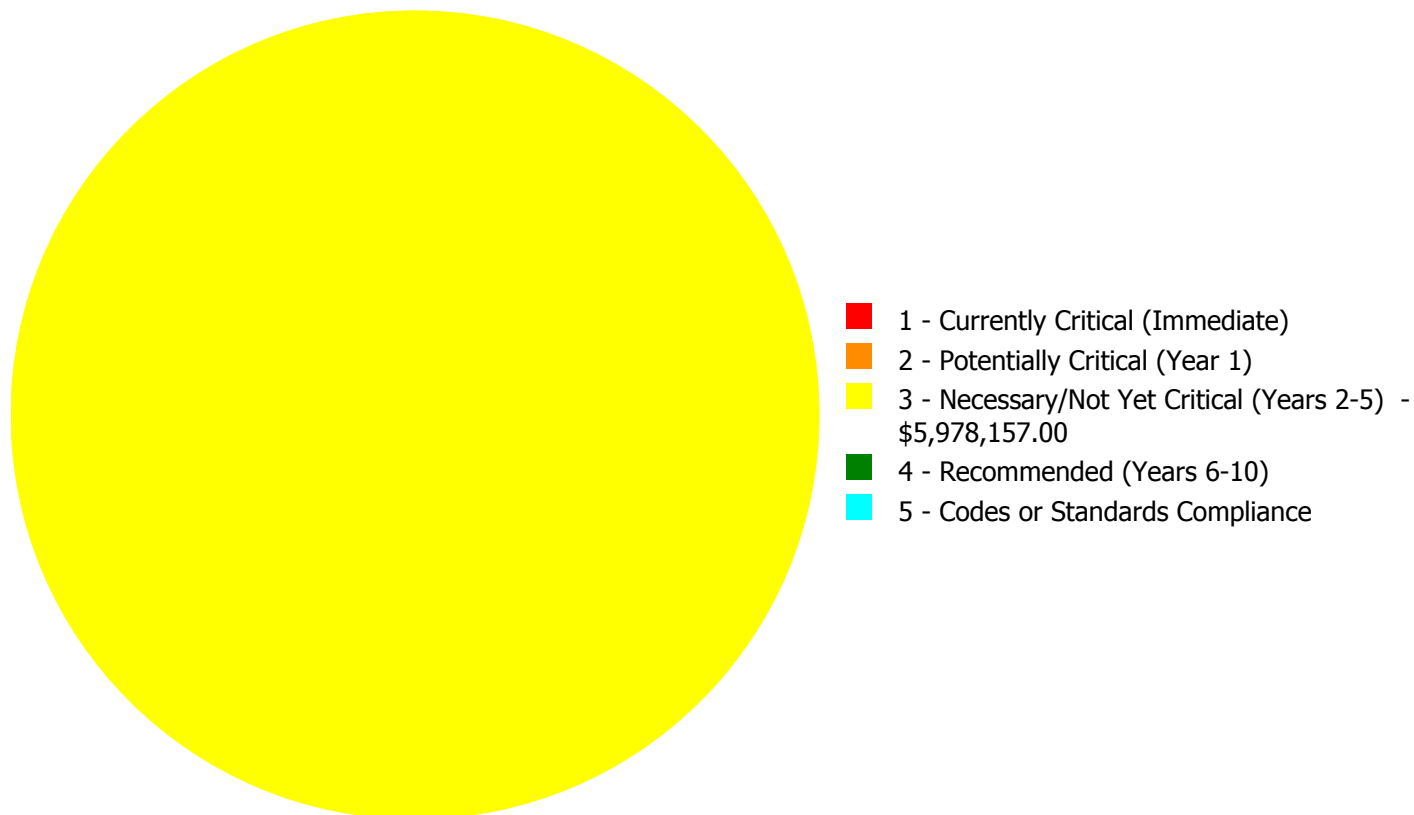
## Deficiency Summary by Priority

The following chart shows the total repair costs broken down by priority. Assessors assigned deficiencies within eCOMET to one of the following priority categories:

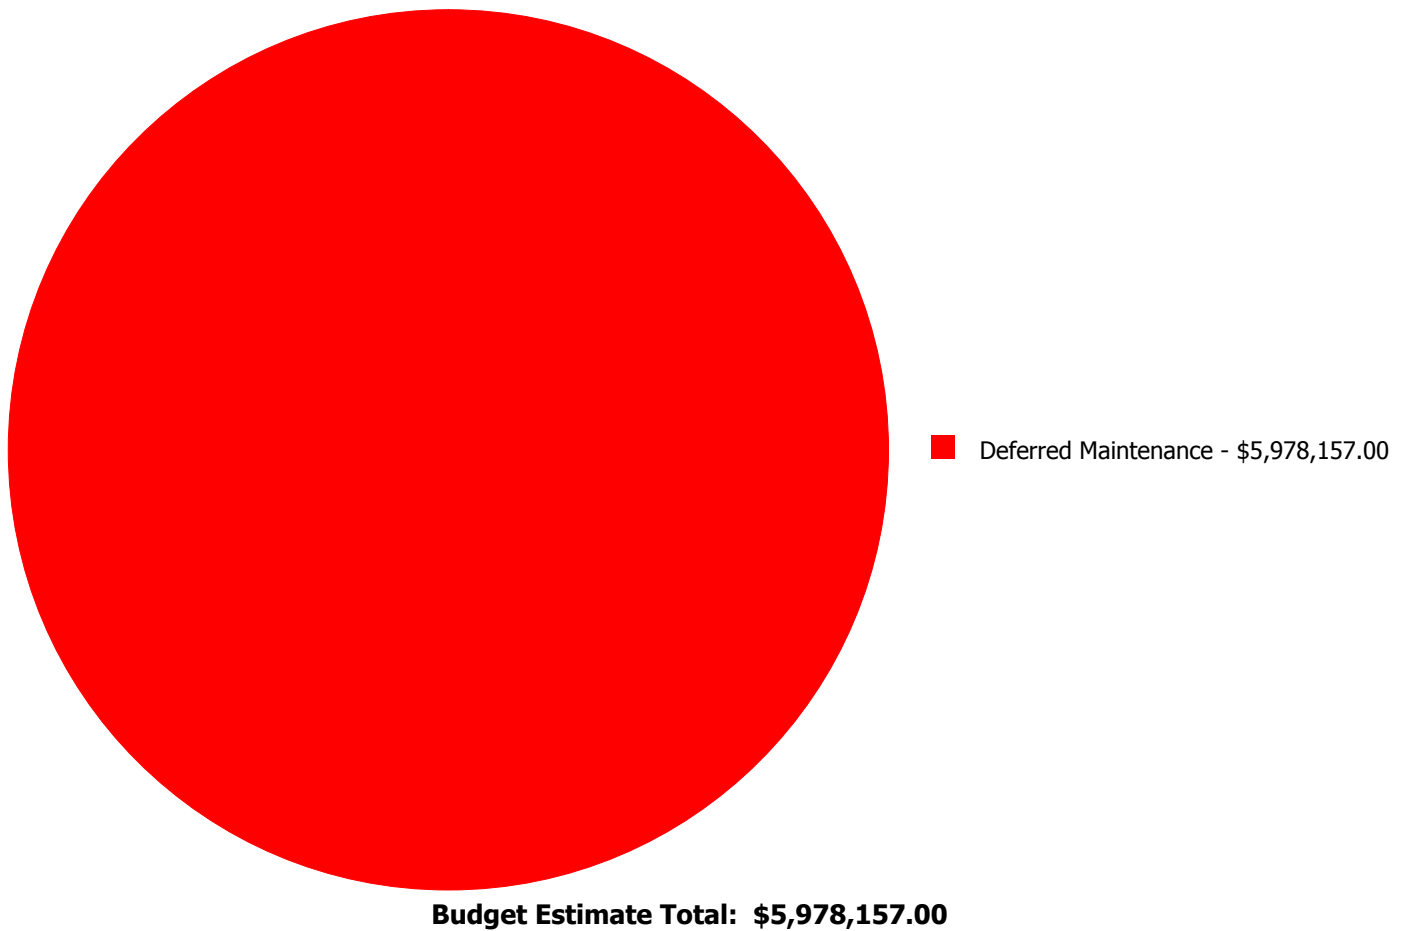
## Deficiency Summary by Category

The following chart shows the total repair costs broken down by deficiency categories. Assessors assigned deficiencies to one of the following categories:

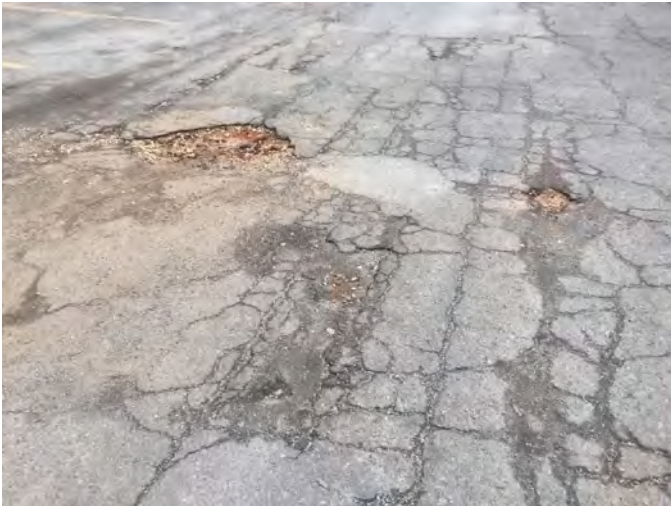
#### System: G2010 - Roadways

**Notes:** The original roadway is aged, has many road cuts, cracks, potholes and repairs and should be re-surfaced.

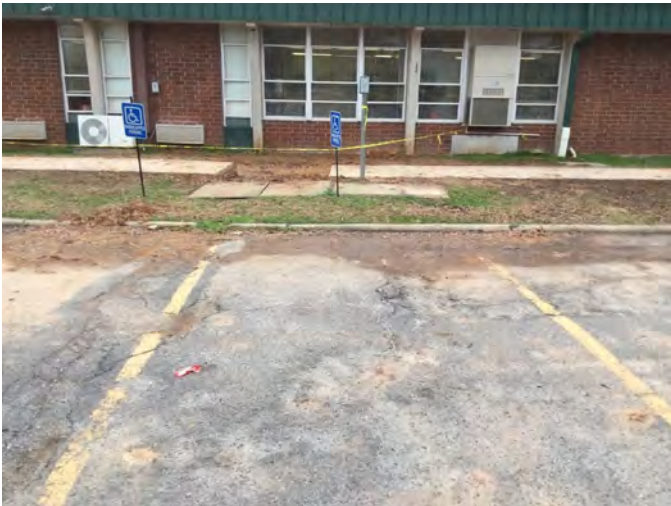
#### System: G2020 - Parking Lots

**Notes:** The parking lot is aged, has many repairs and potholes, and should be replaced and re-stripped.

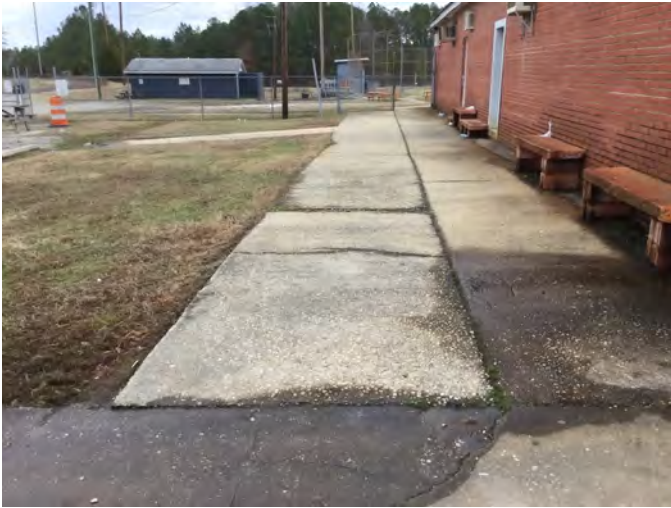
**System: G2030 - Pedestrian Paving**

**Notes:** The pedestrian paving are showing signs of age related and inclement weather damage and should be replaced.

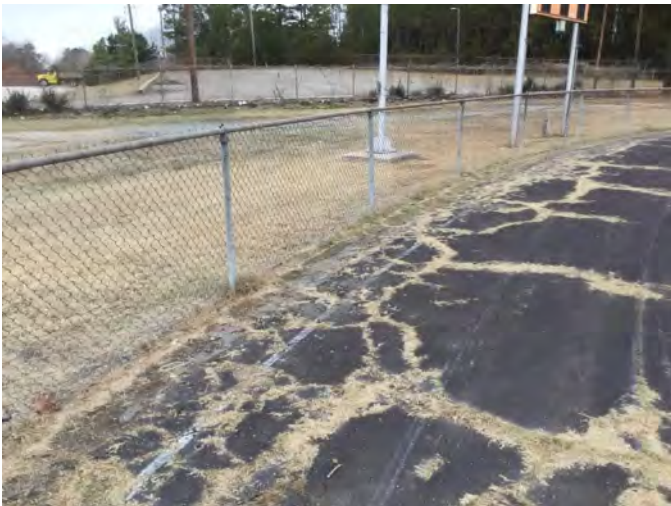
**System: G2040105 - Fence & Guardrails**

**Notes:** The fence & guardrails system is beyond its expected service life and should be scheduled for replacement.

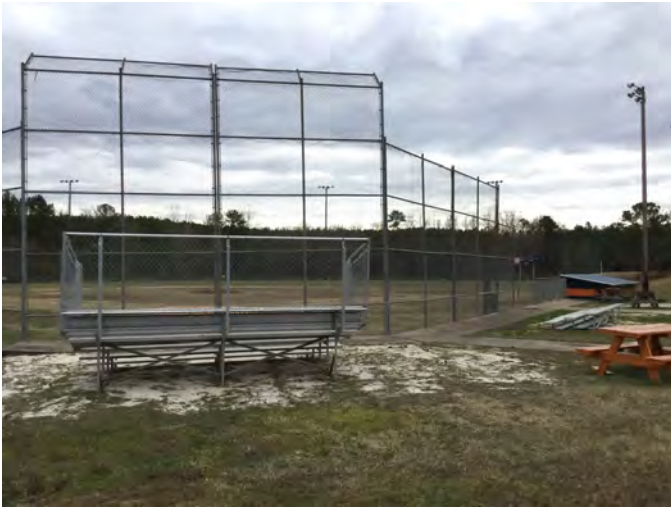
### **System: G2040950 - Baseball Field**

**Notes:** The baseball field system is beyond its expected service life and should be scheduled for replacement.

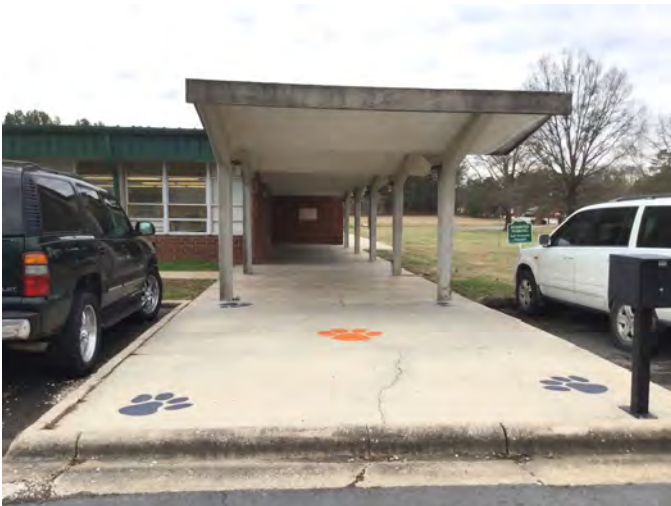
### **System: G2040950 - Covered Walkways**

**Notes:** The covered walkway system is beyond its expected service life and should be scheduled for replacement.

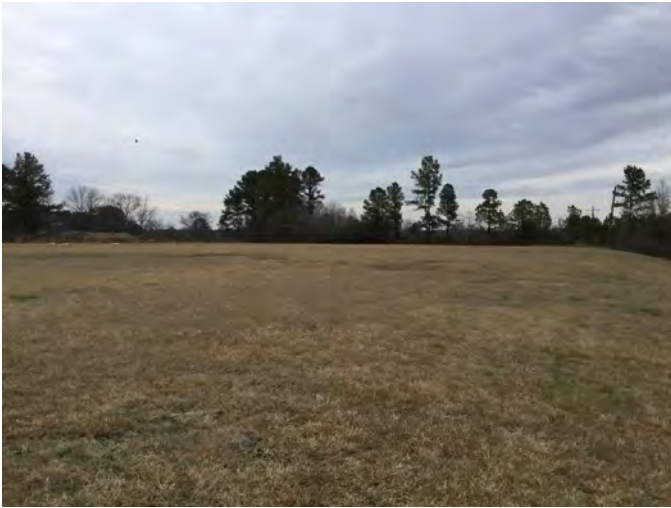
**System: G2040950 - Playing Field**

**Notes:** The playing field system is beyond its expected service life and should be scheduled for replacement.

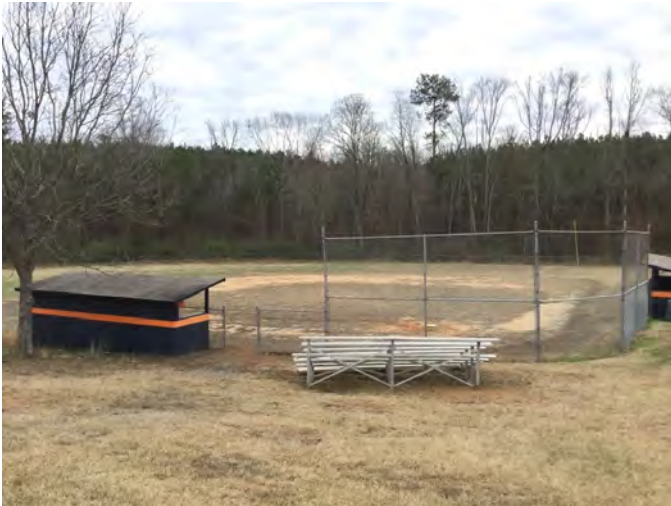
**System: G2040950 - Softball Field**

**Notes:** The softball field system is beyond its expected service life and should be scheduled for replacement.
