# Anson Middle

## Campus Assessment Report

March 7, 2017

## Campus Assessment Report - 1966 Building, Cafe/Gym

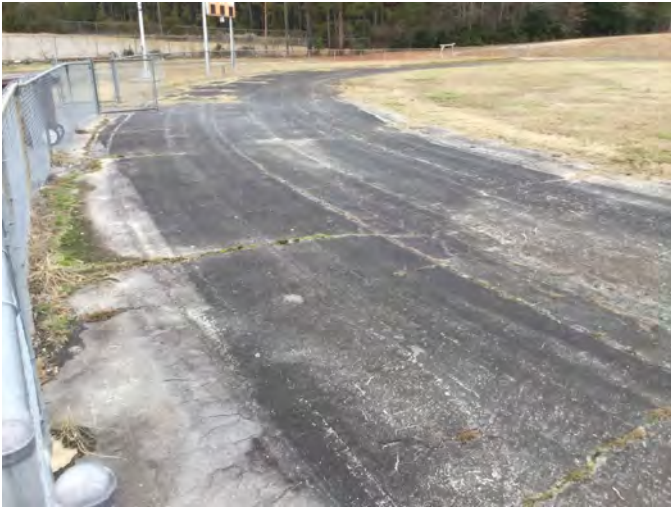
### **System: G2040950 - Track**

**Notes:** The track system is beyond its expected service life and should be scheduled for replacement.

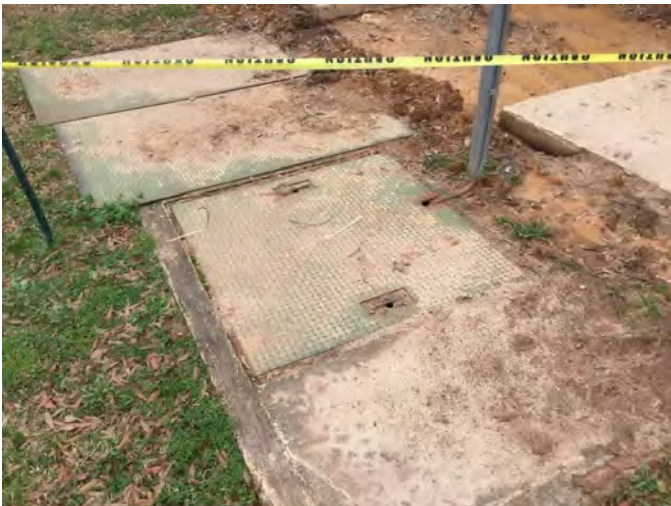
### **System: G3010 - Water Supply**

**Notes:** The water supply system is beyond its expected service life and should be scheduled for replacement.

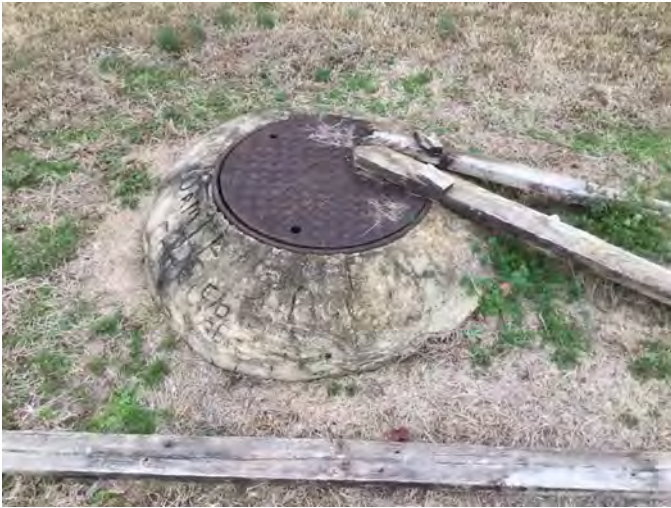
**System: G3020 - Sanitary Sewer**

**Notes:** The sanitary sewer system is beyond its expected service life and should be scheduled for replacement.

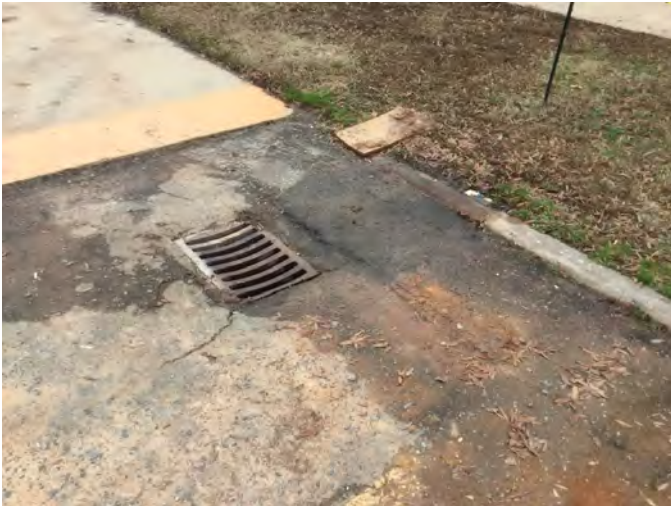
**System: G3030 - Storm Sewer**

**Notes:** The storm sewer system is beyond its expected service life and should be scheduled for replacement.

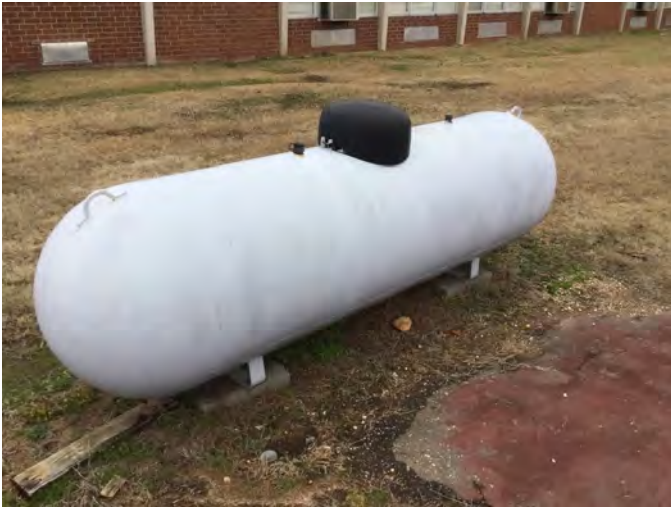
**System: G3060 - Fuel Distribution**

**Notes:** The fuel distribution system is beyond its expected service life and should be scheduled for replacement.

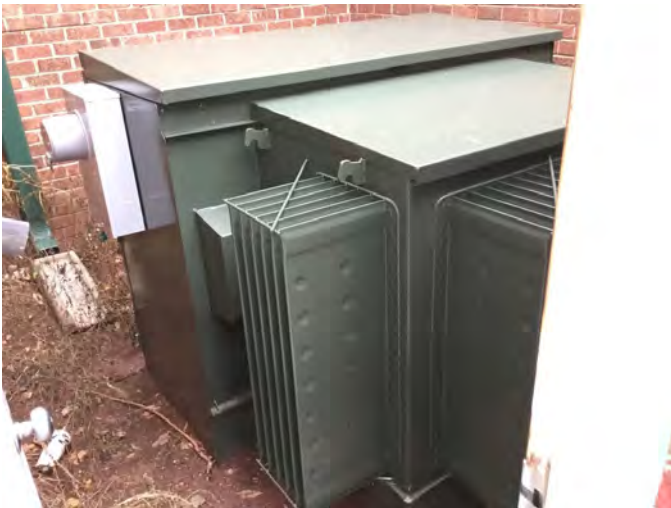
**System: G4010 - Electrical Distribution**

**Notes:** The electrical distribution system is beyond its expected service life and should be scheduled for replacement.

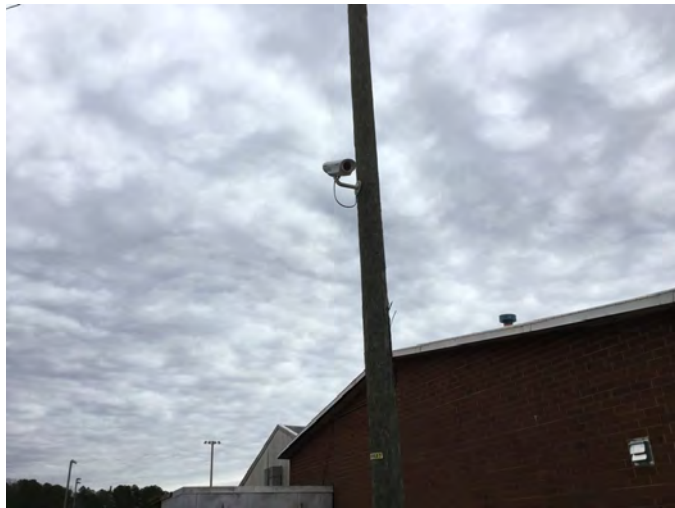
**System: G4030 - Site Communications & Security**

**Notes:** The site communication & security system is beyond its expected service life and should be scheduled for replacement.

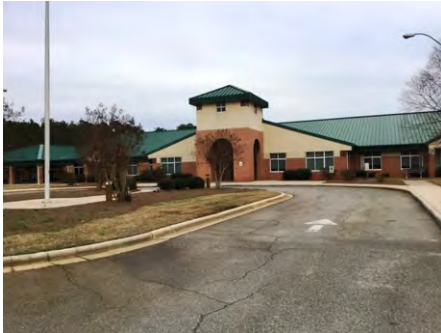
1). West Elevation - Jan 19, 2017

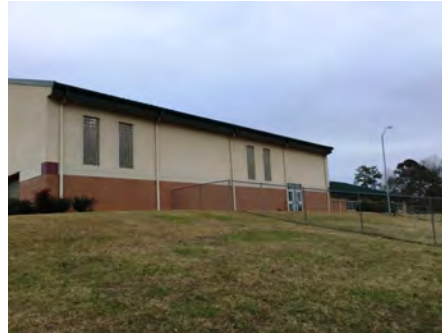
2). Southwest Elevation - Jan 19, 2017

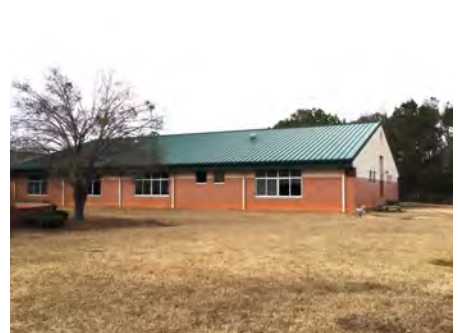
3). South Elevation - Jan 19, 2017

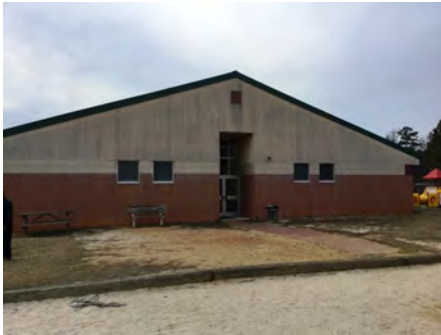
4). East Elevation - Jan 19, 2017

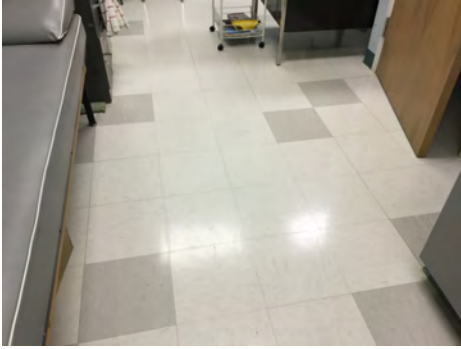
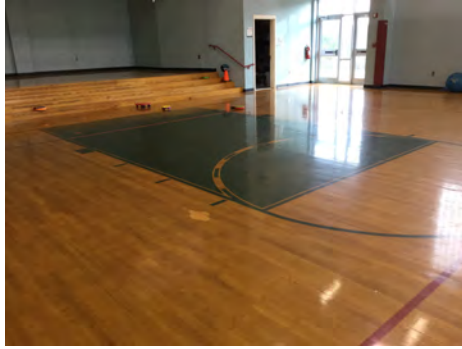
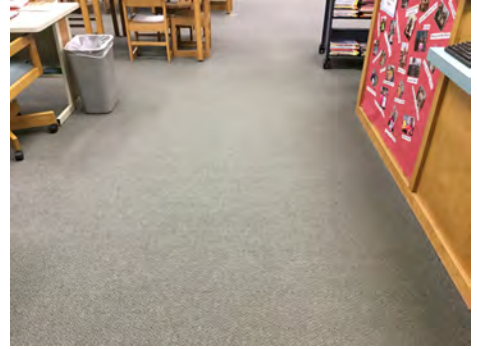
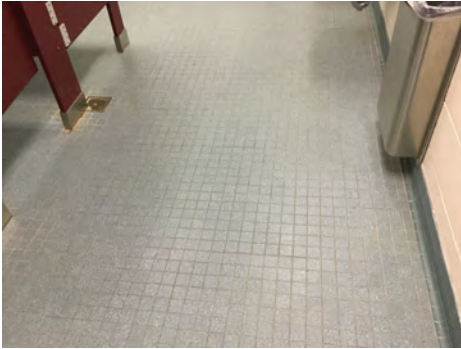
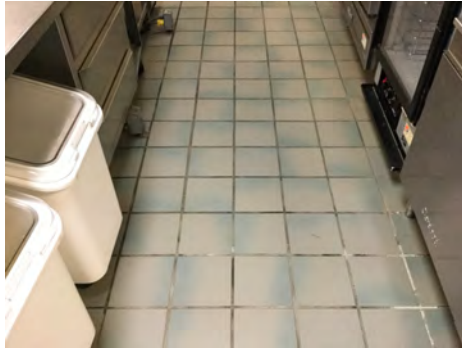
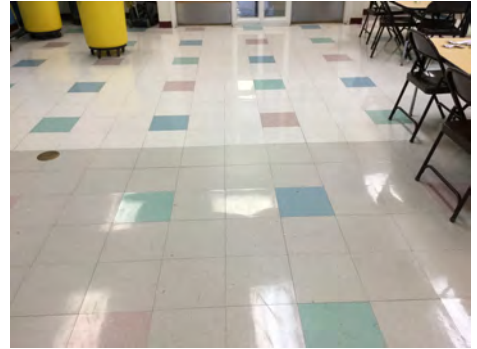
### System: C3020 - Floor Finishes

**Note:** Carpet needs to be replaced. 2% of VCT needs to be replaced.

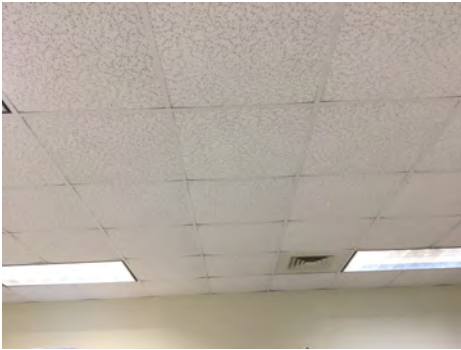
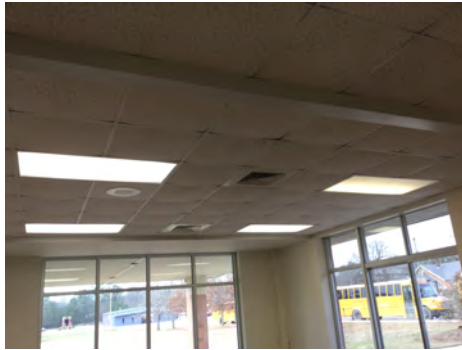
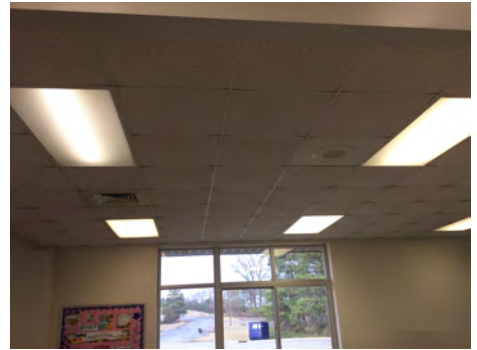
### System: C3030 - Ceiling Finishes

**Note:** The acoustical ceiling tiles are beyond their service life and should be replaced.

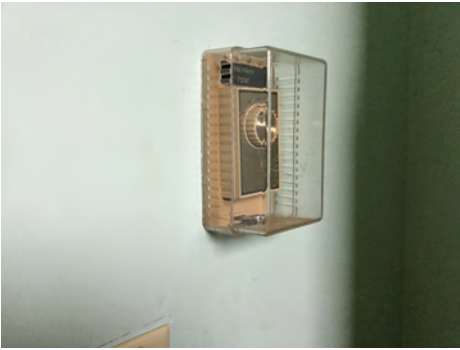
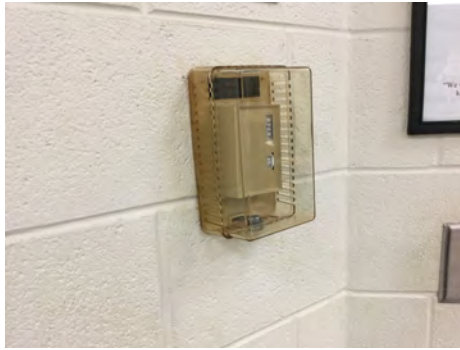
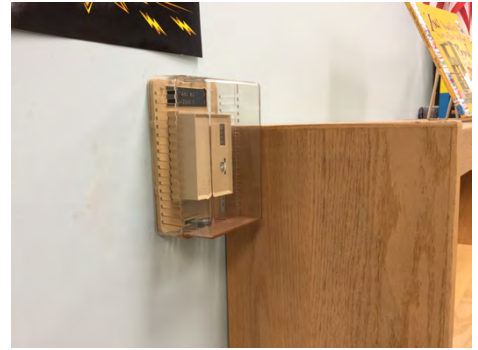
**System:** D3060 - Controls & Instrumentation

**Note:** The controls and instrumentation system is beyond its service life and should be replaced.

**Notes:** The controls and instrumentation system is beyond its service life and should be replaced.

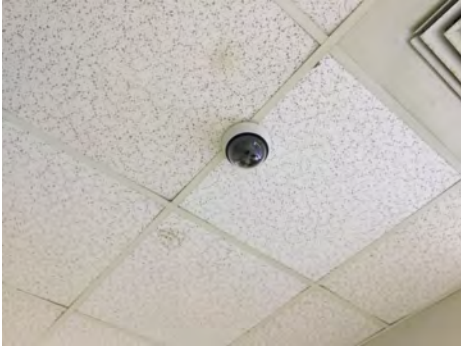
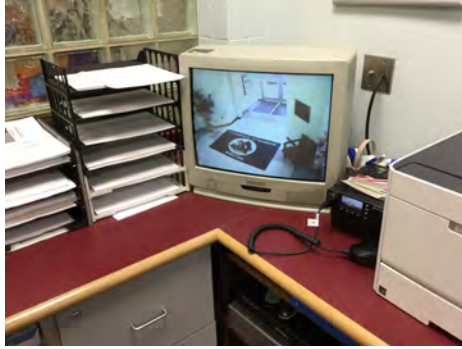
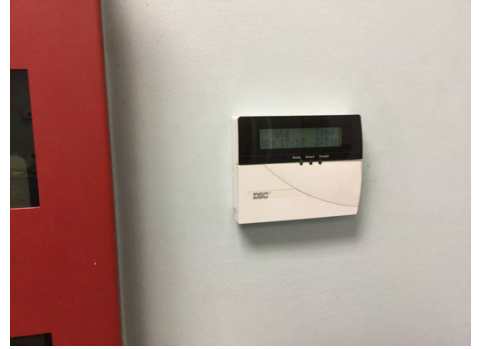
### System: D5030810 - Security & Detection Systems

**Note:** The security and detection system is beyond its service life and should be replaced.

**Notes:** The security and detection system is beyond its service life and should be replaced.

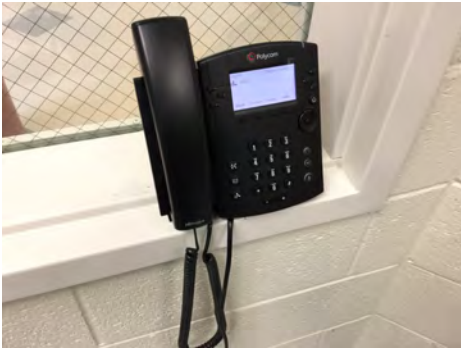
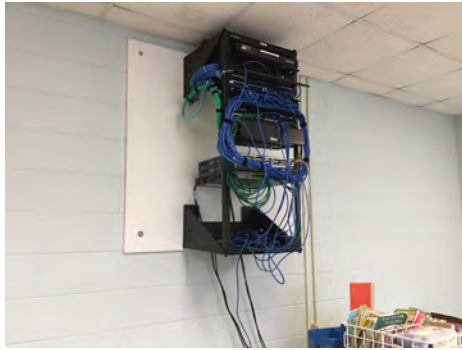
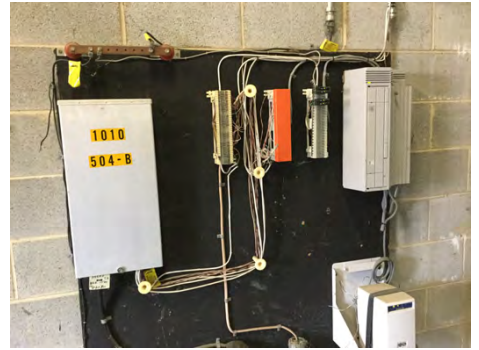
### System: D5030920 - Data Communication

**Note:** The data and communications system is beyond its service life and should be replaced.

**Notes:** The data and communications system is beyond its service life and should be replaced.

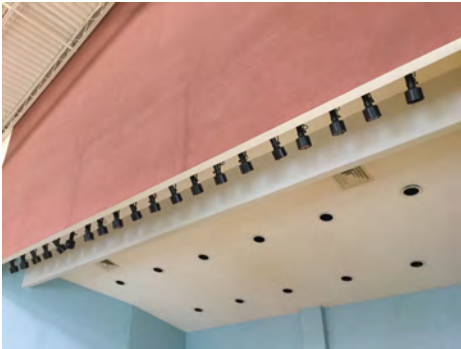
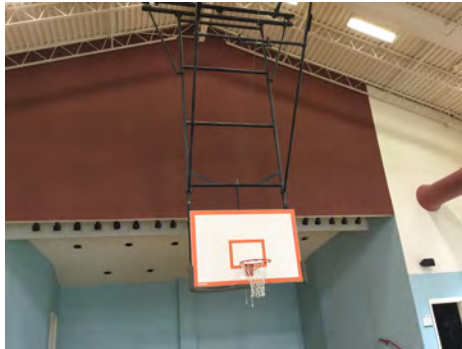
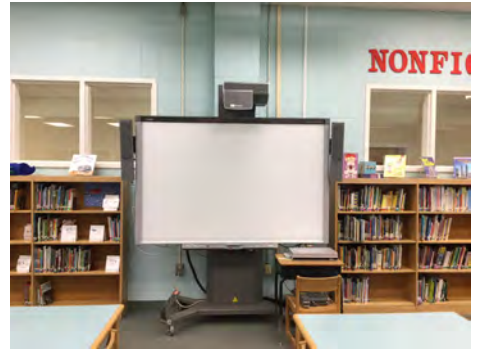
**System:** E1020 - Institutional Equipment

**Note:** The institutional equipment is beyond its service life and should be replaced.

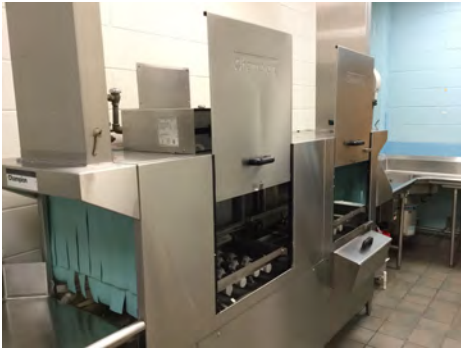
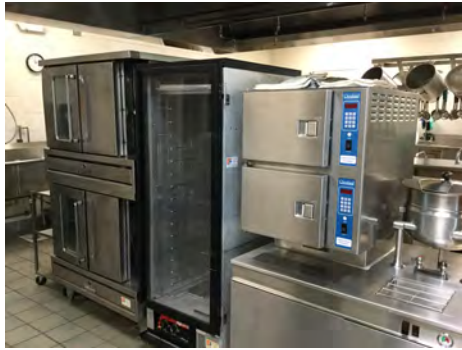
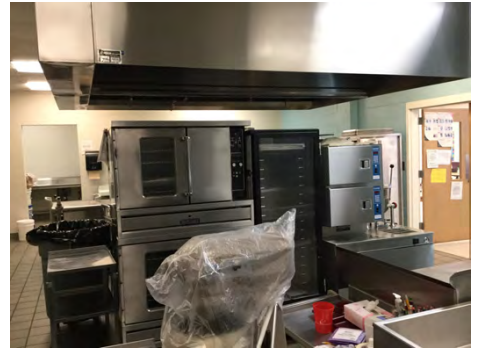
**System:** E1090 - Other Equipment

**Note:** The kitchen equipment is beyond its service life and should be replaced.

**Notes:** The kitchen equipment is beyond its service life and should be replaced.

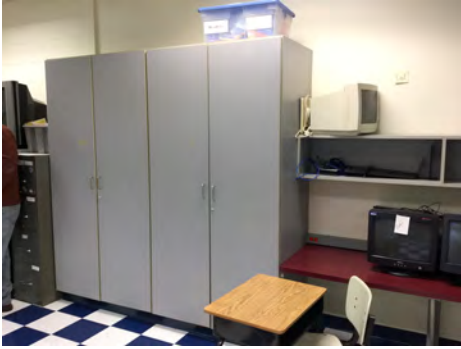
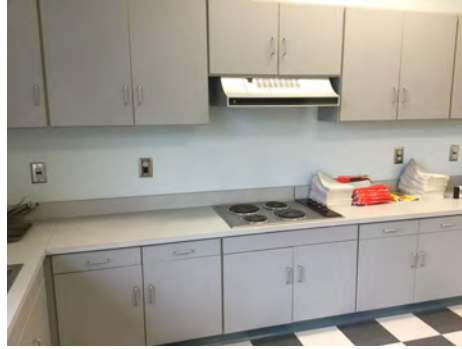
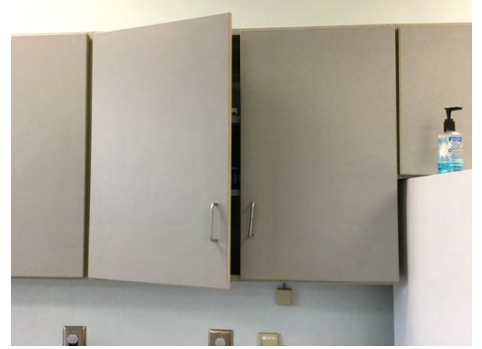
**System:** E2010 - Fixed Furnishings

**Note:** The fixed furnishings are beyond their service life and should be replaced.

**Notes:** The fixed furnishings are beyond their service life and should be replaced.

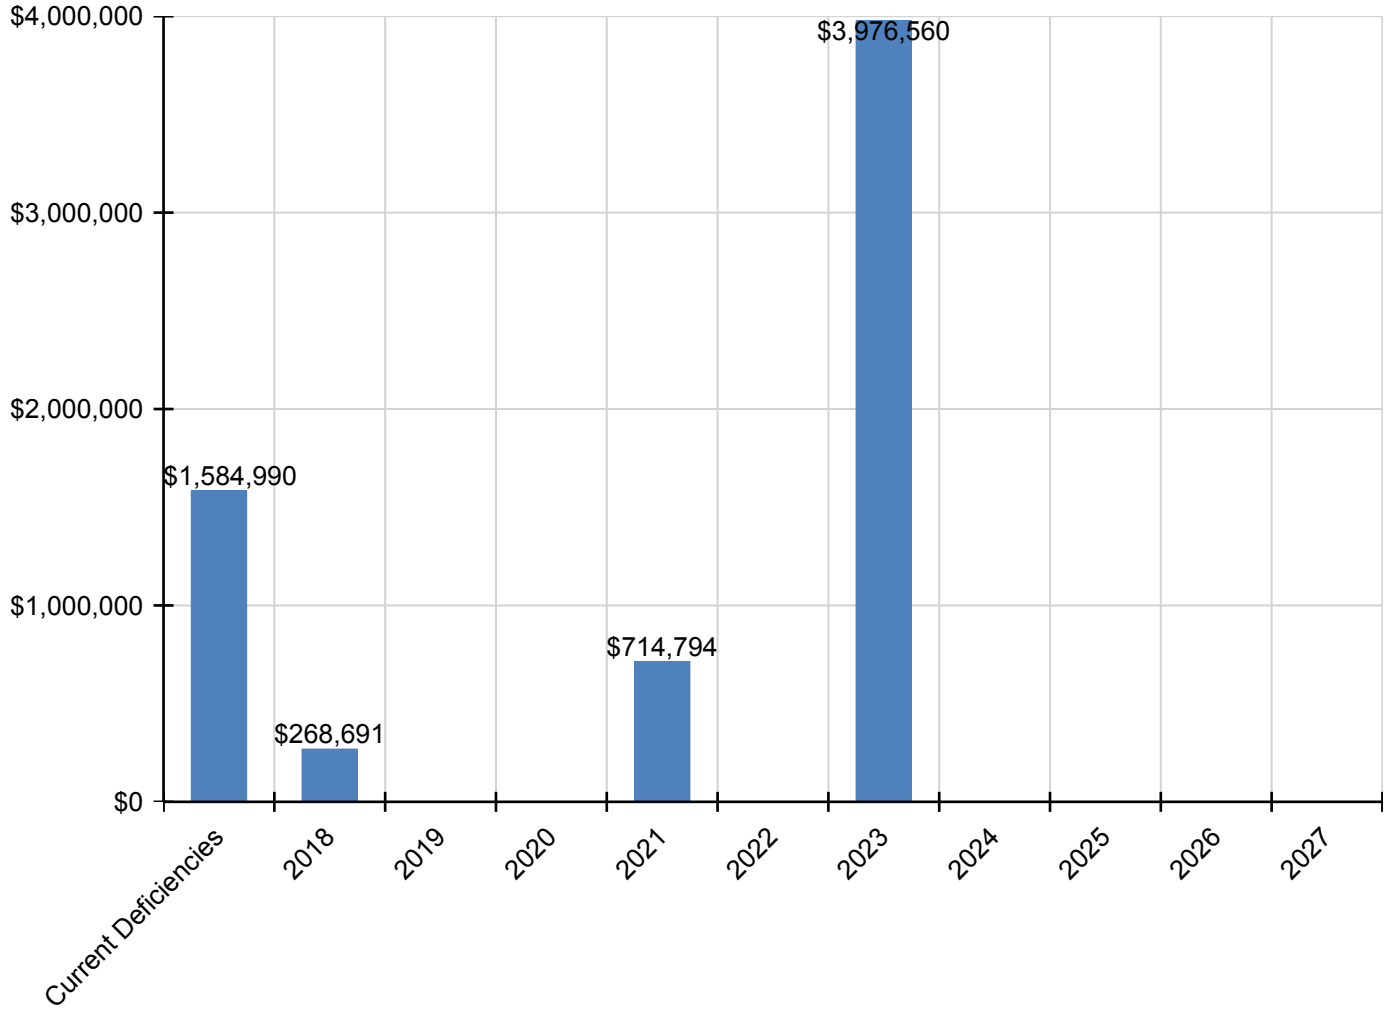
## Forecasted Capital Renewal Requirement

The following chart shows the current building deficiencies and forecasting capital renewal or sustainment requirements over the next ten years.

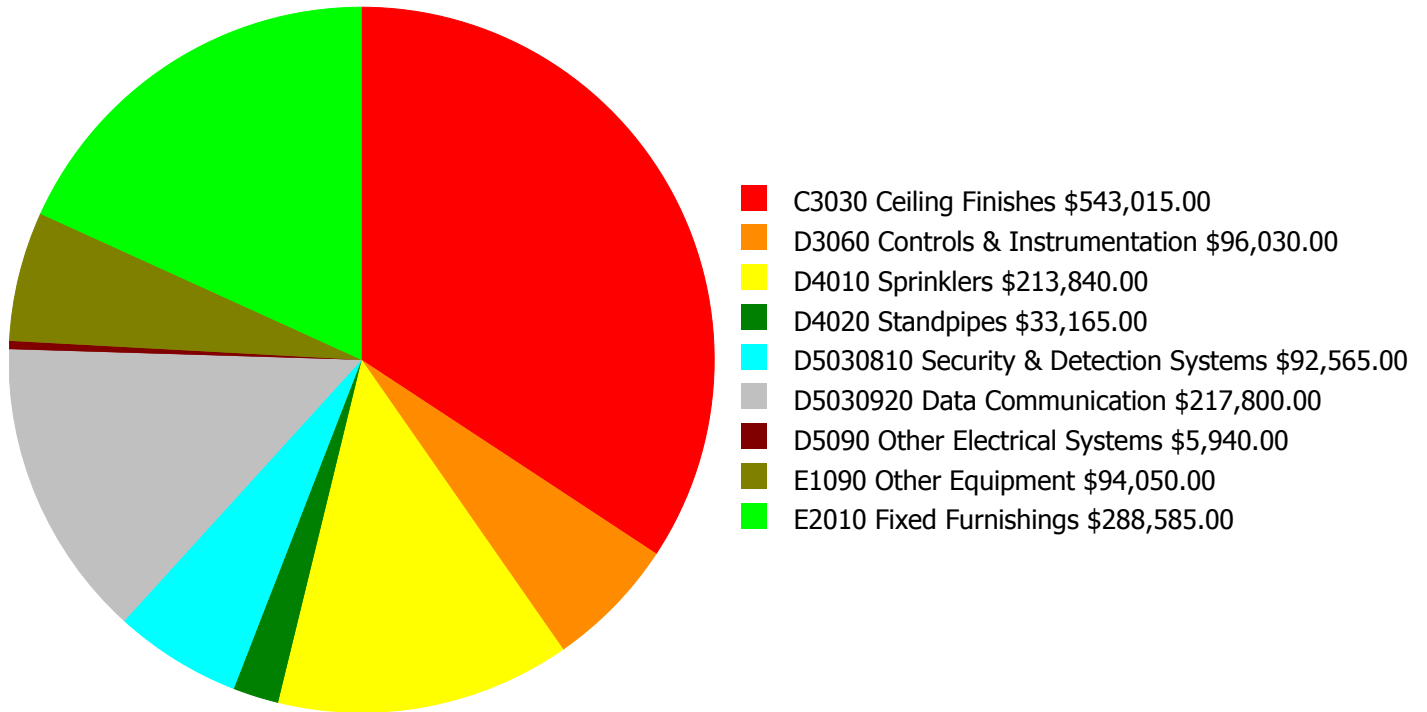
## Deficiency Summary by System

Current deficiencies included assemblies that have reached or exceeded their design life or components of the assemblies that are in need of repair. Assemblies that have reached their design life are identified as current deficiencies and assigned the distress 'Beyond Useful Life'. The following chart lists all current deficiencies associated with this facility.

**Budget Estimate Total: \$1,584,990.00**

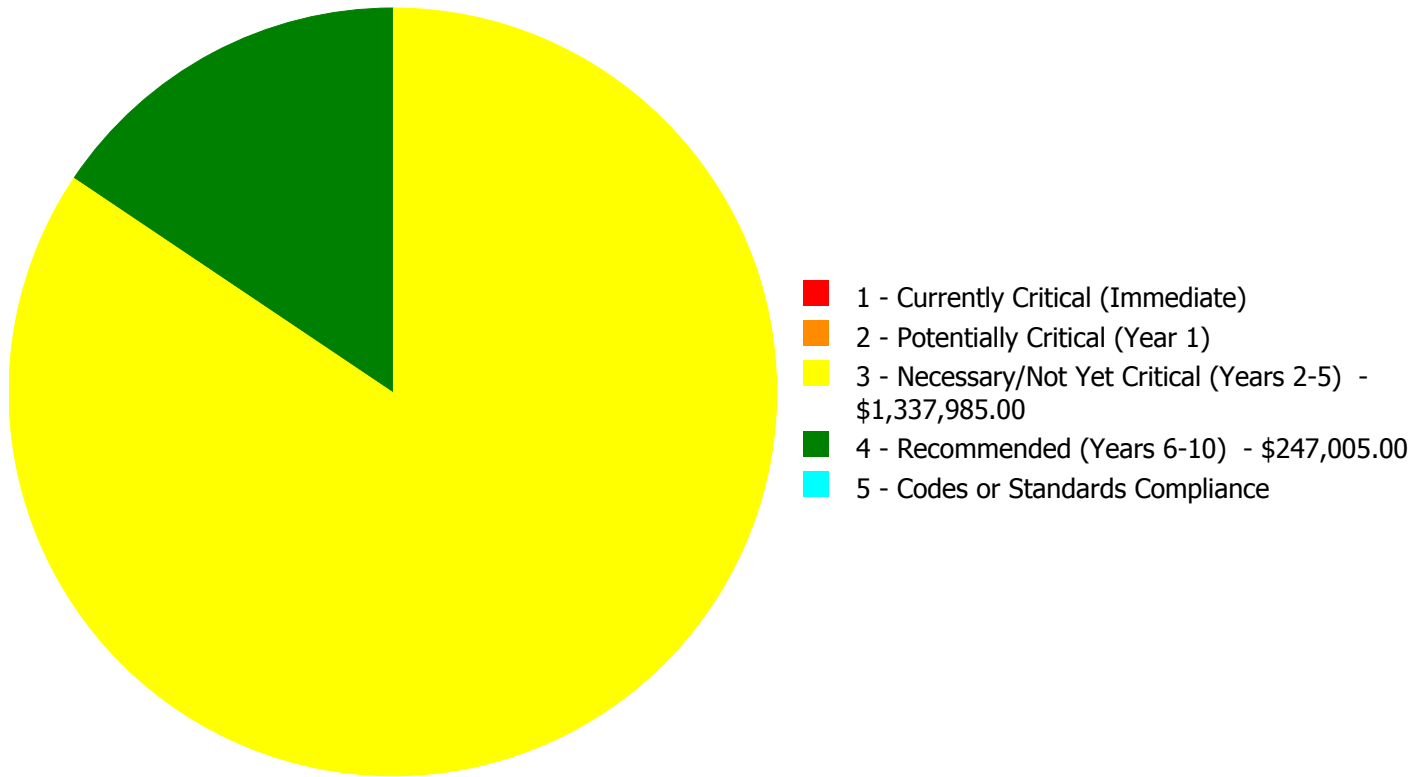
## Deficiency Summary by Priority

The following chart shows the total repair costs broken down by priority. Assessors assigned deficiencies within eCOMET to one of the following priority categories:

**Budget Estimate Total: \$1,584,990.00**

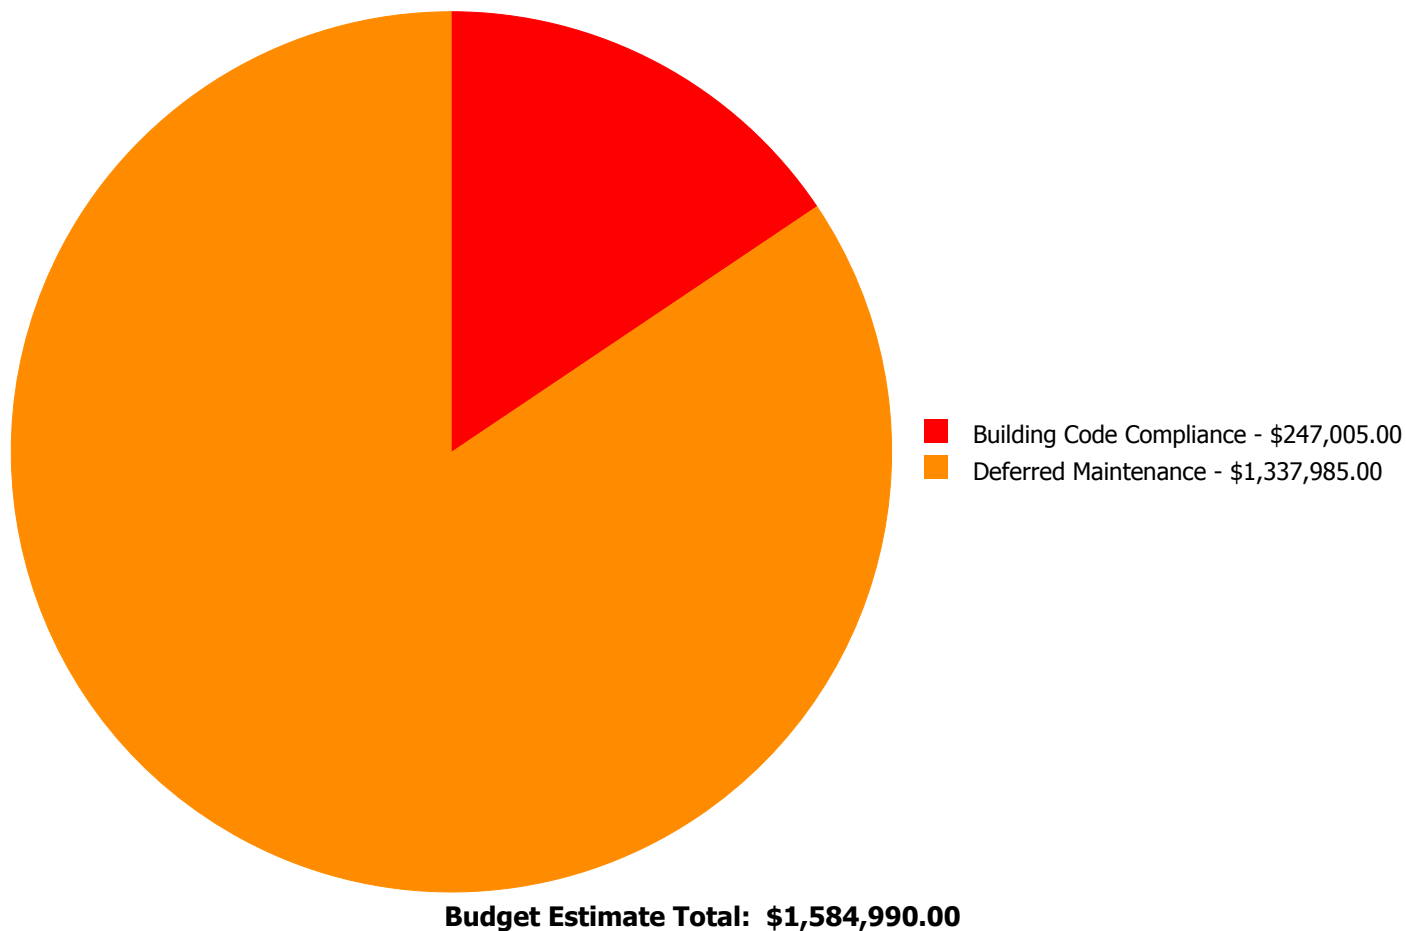
### Deficiency Summary by Category

The following chart shows the total repair costs broken down by deficiency categories. Assessors assigned deficiencies to one of the following categories:

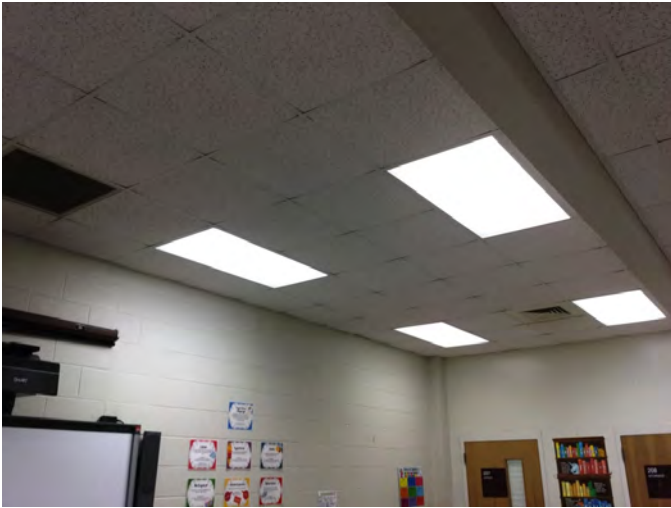
#### System: C3030 - Ceiling Finishes

**Location:** Throughout Building  
**Distress:** Beyond Service Life  
**Category:** Deferred Maintenance  
**Priority:** 3 - Necessary/Not Yet Critical (Years 2-5)  
**Correction:** Renew System  
**Qty:** 45,000.00  
**Unit of Measure:** S.F.  
**Estimate:** \$543,015.00  
**Assessor Name:** Eduardo Lopez  
**Date Created:** 01/18/2017

**Notes:** The acoustical ceiling tiles are beyond their service life and should be replaced.

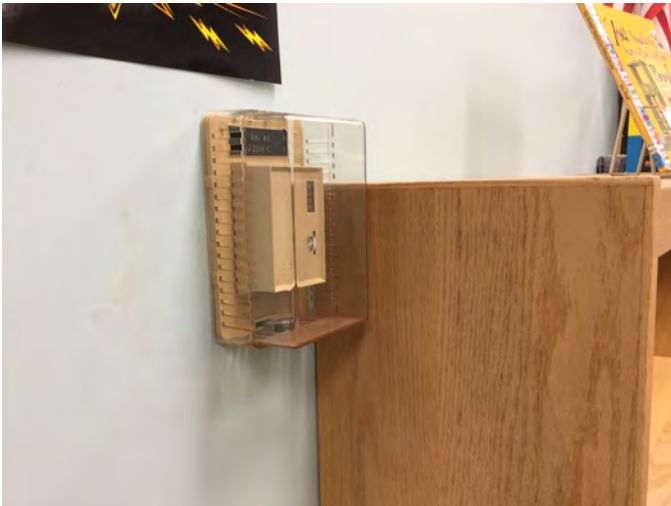
#### System: D3060 - Controls & Instrumentation

**Location:** Throughout Building  
**Distress:** Beyond Service Life  
**Category:** Deferred Maintenance  
**Priority:** 3 - Necessary/Not Yet Critical (Years 2-5)  
**Correction:** Renew System  
**Qty:** 45,000.00  
**Unit of Measure:** S.F.  
**Estimate:** \$96,030.00  
**Assessor Name:** Eduardo Lopez  
**Date Created:** 01/17/2017

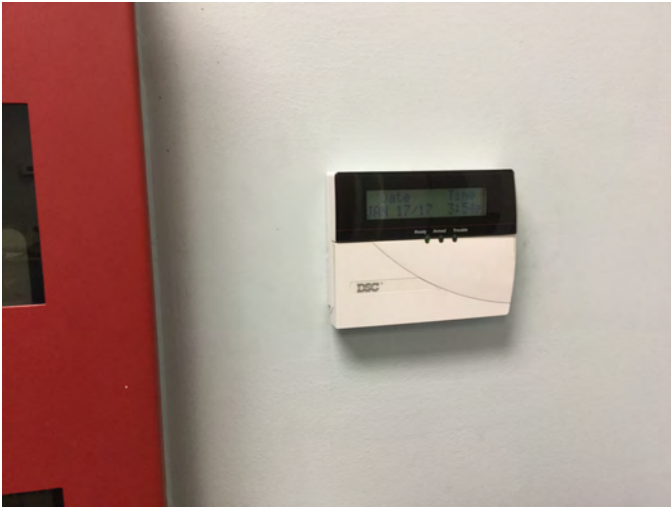
**System: D5030810 - Security & Detection Systems**

**Location:** Throughout Building  
**Distress:** Beyond Service Life  
**Category:** Deferred Maintenance  
**Priority:** 3 - Necessary/Not Yet Critical (Years 2-5)  
**Correction:** Renew System  
**Qty:** 45,000.00  
**Unit of Measure:** S.F.  
**Estimate:** \$92,565.00  
**Assessor Name:** Eduardo Lopez  
**Date Created:** 01/17/2017

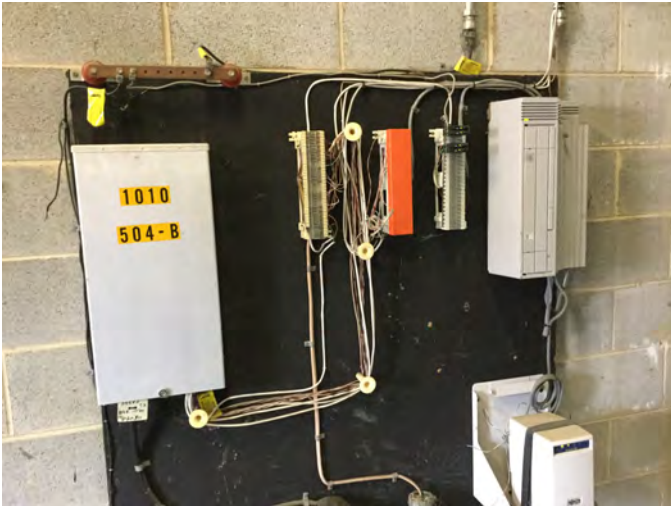
**System: D5030920 - Data Communication**

**Location:** Throughout Building  
**Distress:** Beyond Service Life  
**Category:** Deferred Maintenance  
**Priority:** 3 - Necessary/Not Yet Critical (Years 2-5)  
**Correction:** Renew System  
**Qty:** 45,000.00  
**Unit of Measure:** S.F.  
**Estimate:** \$217,800.00  
**Assessor Name:** Eduardo Lopez  
**Date Created:** 01/17/2017

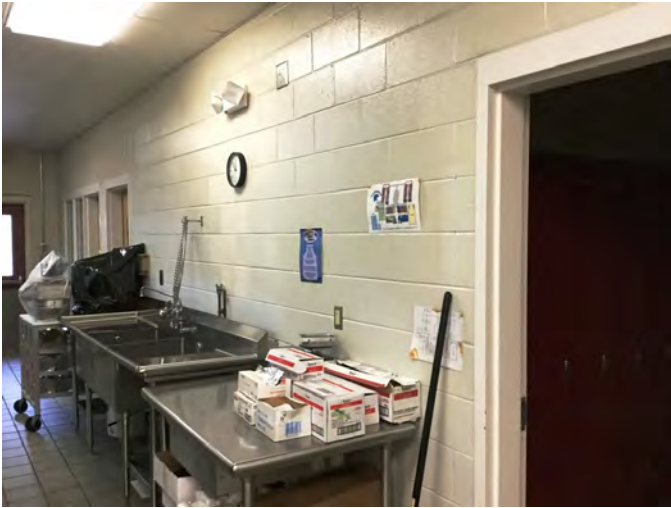
**System: D5090 - Other Electrical Systems**

**Location:** Throughout Building  
**Distress:** Beyond Service Life  
**Category:** Deferred Maintenance  
**Priority:** 3 - Necessary/Not Yet Critical (Years 2-5)  
**Correction:** Renew System  
**Qty:** 45,000.00  
**Unit of Measure:** S.F.  
**Estimate:** \$5,940.00  
**Assessor Name:** Eduardo Lopez  
**Date Created:** 02/24/2017

**Notes:** The emergency light system is beyond its service life and should be replaced.

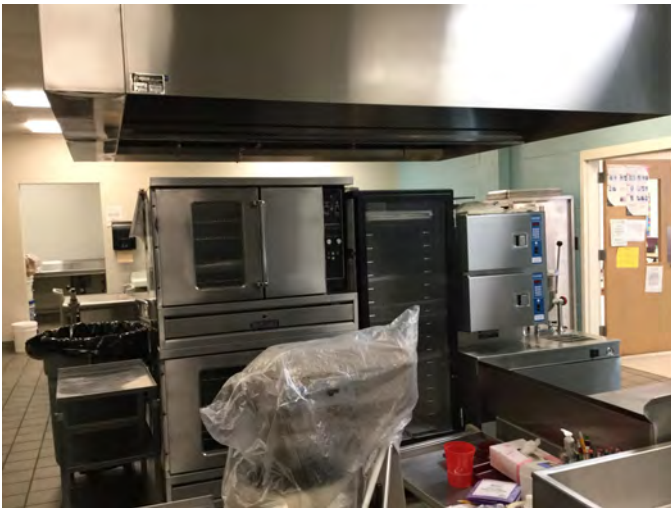
**System: E1090 - Other Equipment**

**Location:** Kitchen  
**Distress:** Beyond Service Life  
**Category:** Deferred Maintenance  
**Priority:** 3 - Necessary/Not Yet Critical (Years 2-5)  
**Correction:** Renew System  
**Qty:** 45,000.00  
**Unit of Measure:** S.F.  
**Estimate:** \$94,050.00  
**Assessor Name:** Eduardo Lopez  
**Date Created:** 01/17/2017

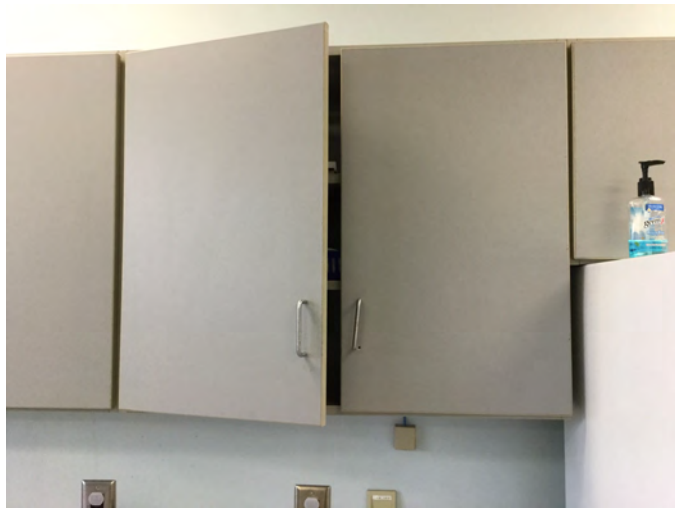
**System: E2010 - Fixed Furnishings**

**Location:** Throughout Building  
**Distress:** Beyond Service Life  
**Category:** Deferred Maintenance  
**Priority:** 3 - Necessary/Not Yet Critical (Years 2-5)  
**Correction:** Renew System  
**Qty:** 45,000.00  
**Unit of Measure:** S.F.  
**Estimate:** \$288,585.00  
**Assessor Name:** Eduardo Lopez  
**Date Created:** 01/17/2017

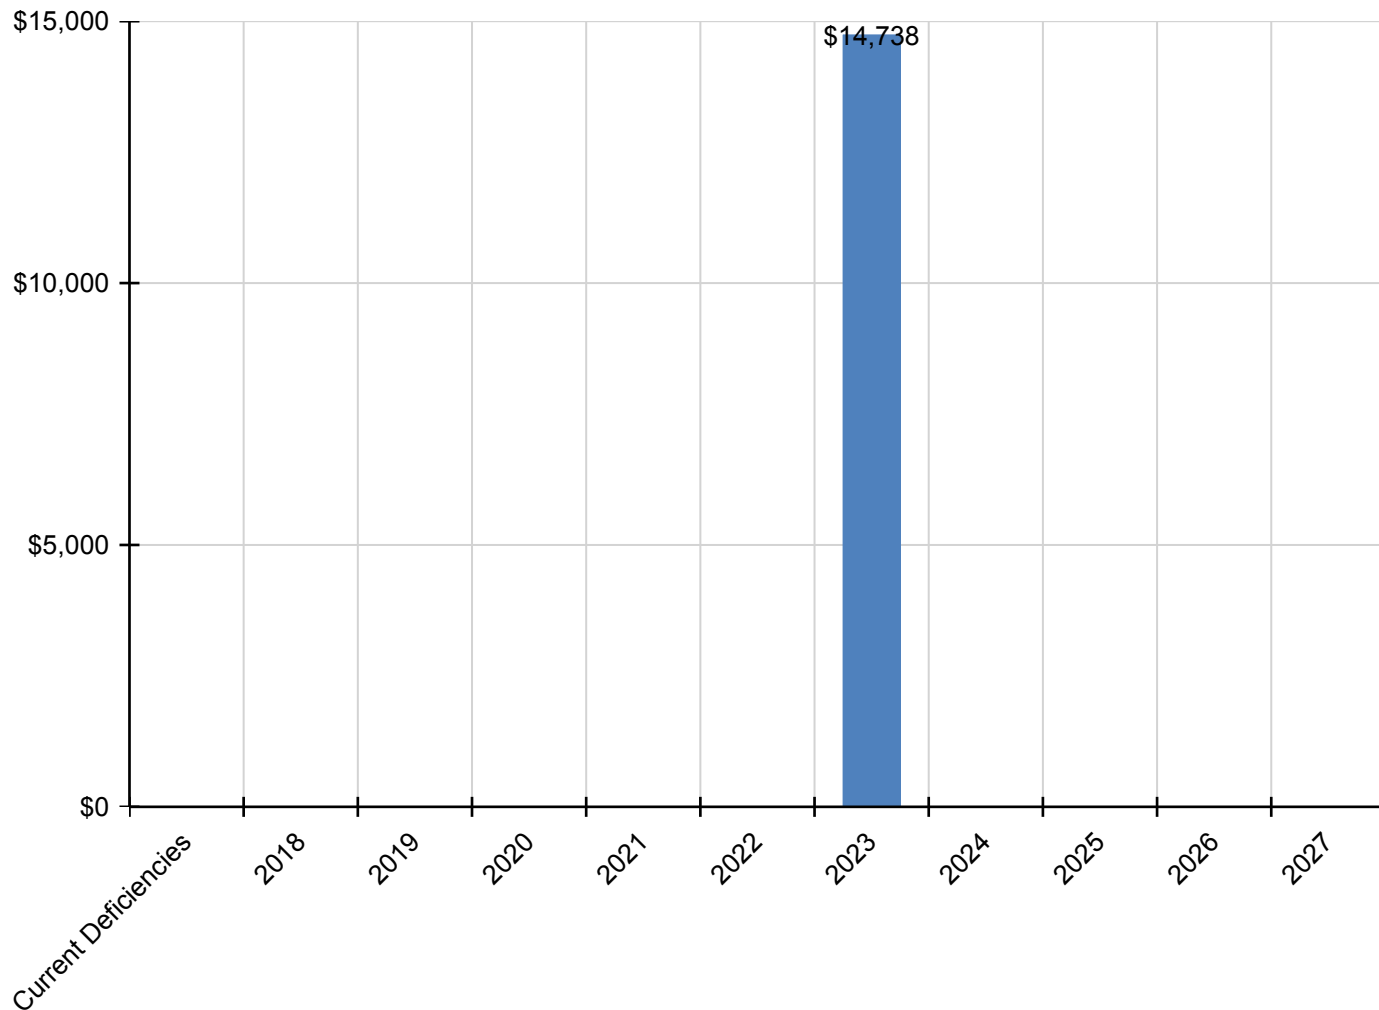
### Forecasted Capital Renewal Requirement

The following chart shows the current building deficiencies and forecasting capital renewal or sustainment requirements over the next ten years.

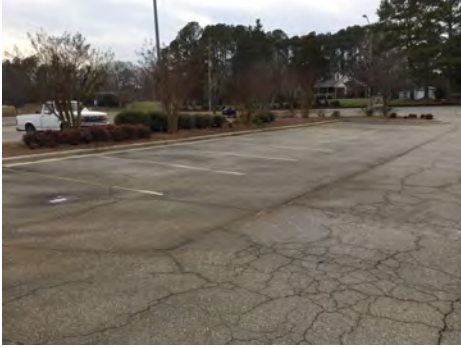
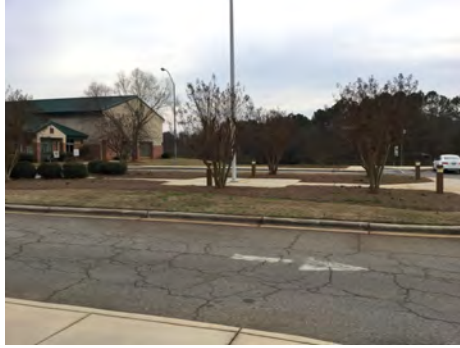
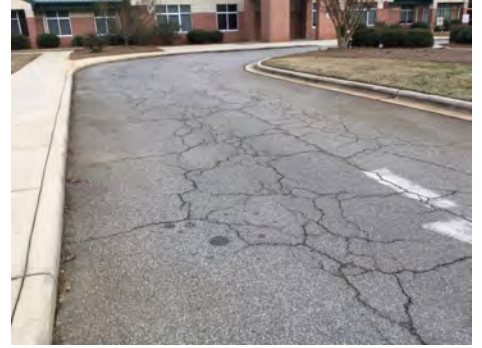
**System:** G2010 - Roadways

**Note:** The roadways are beyond their service life and should be replaced.

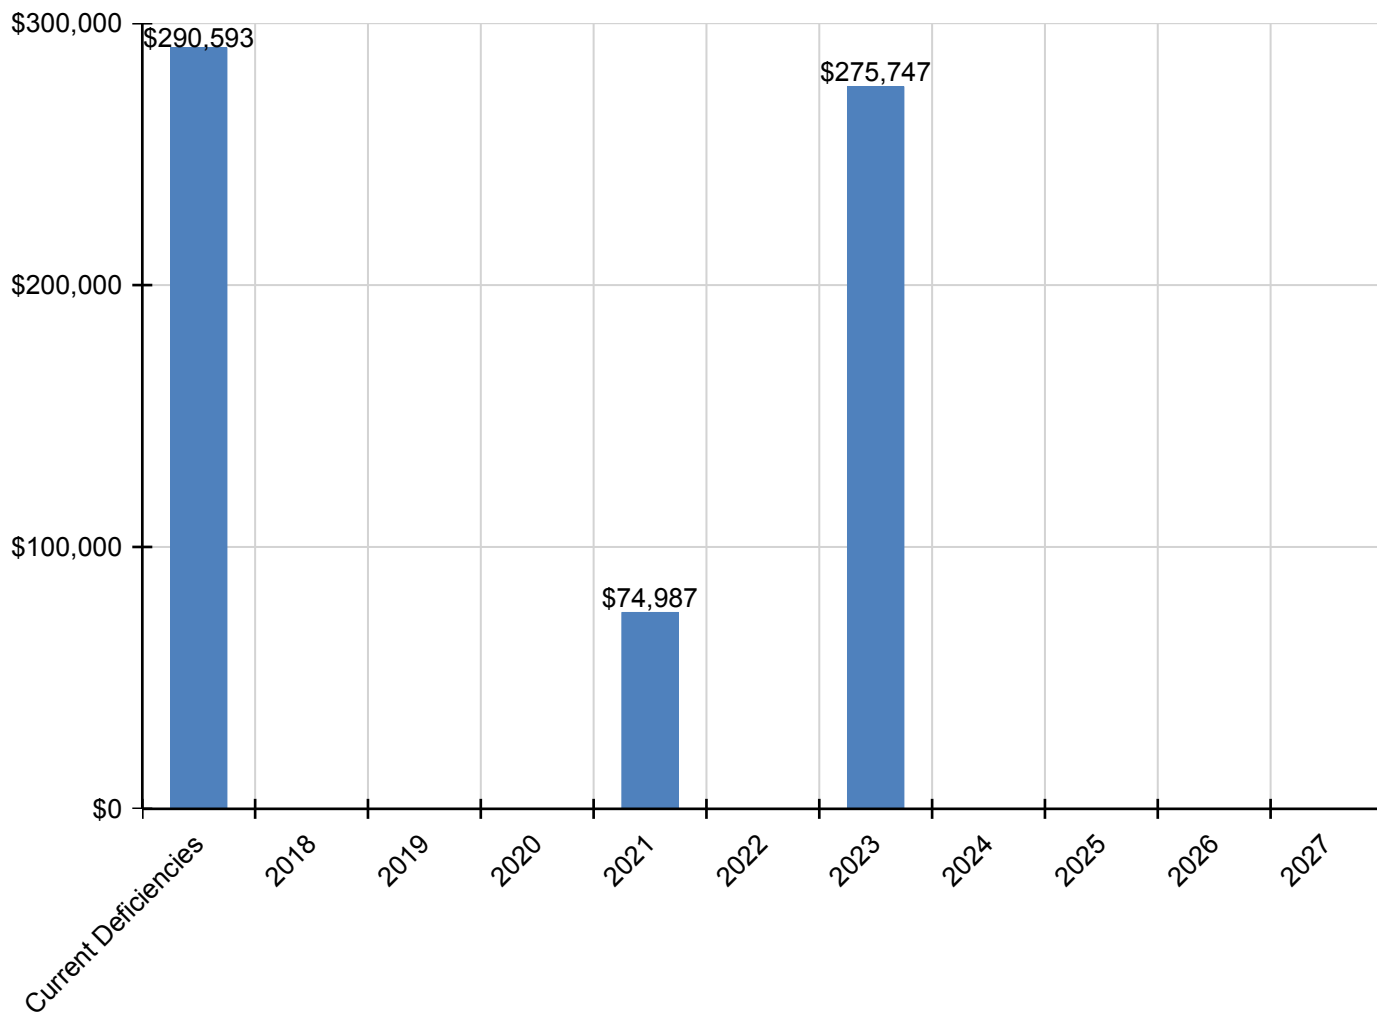
## Forecasted Capital Renewal Requirement

The following chart shows the current building deficiencies and forecasting capital renewal or sustainment requirements over the next ten years.

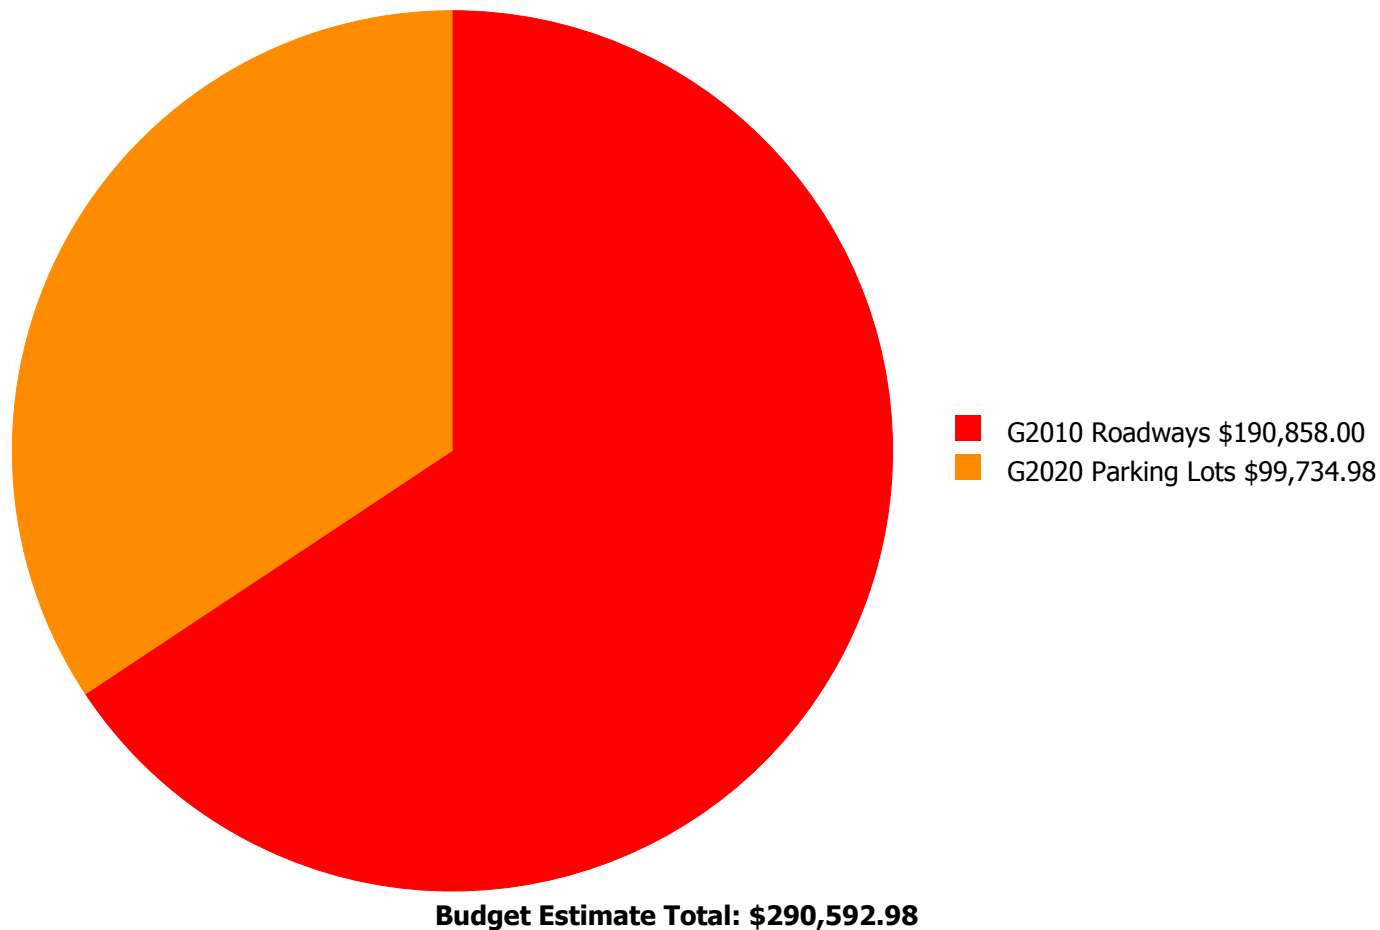
## Deficiency Summary by System

Current deficiencies included assemblies that have reached or exceeded their design life or components of the assemblies that are in need of repair. Assemblies that have reached their design life are identified as current deficiencies and assigned the distress 'Beyond Useful Life'. The following chart lists all current deficiencies associated with this facility.

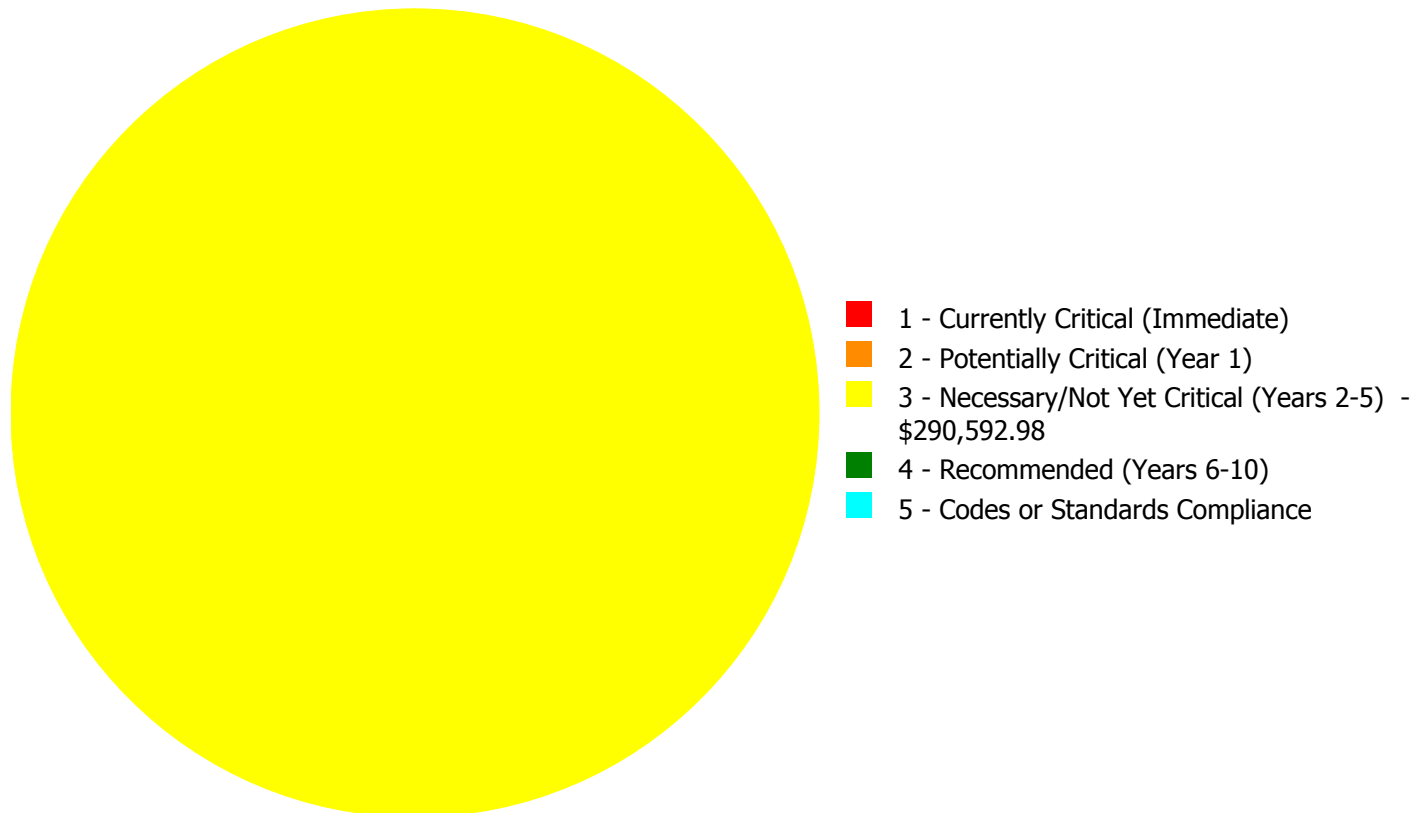
## Deficiency Summary by Priority

The following chart shows the total repair costs broken down by priority. Assessors assigned deficiencies within eCOMET to one of the following priority categories:
