# Anson Middle

## Campus Assessment Report

March 7, 2017

## Campus Assessment Report - 1966 Building, Cafe/Gym

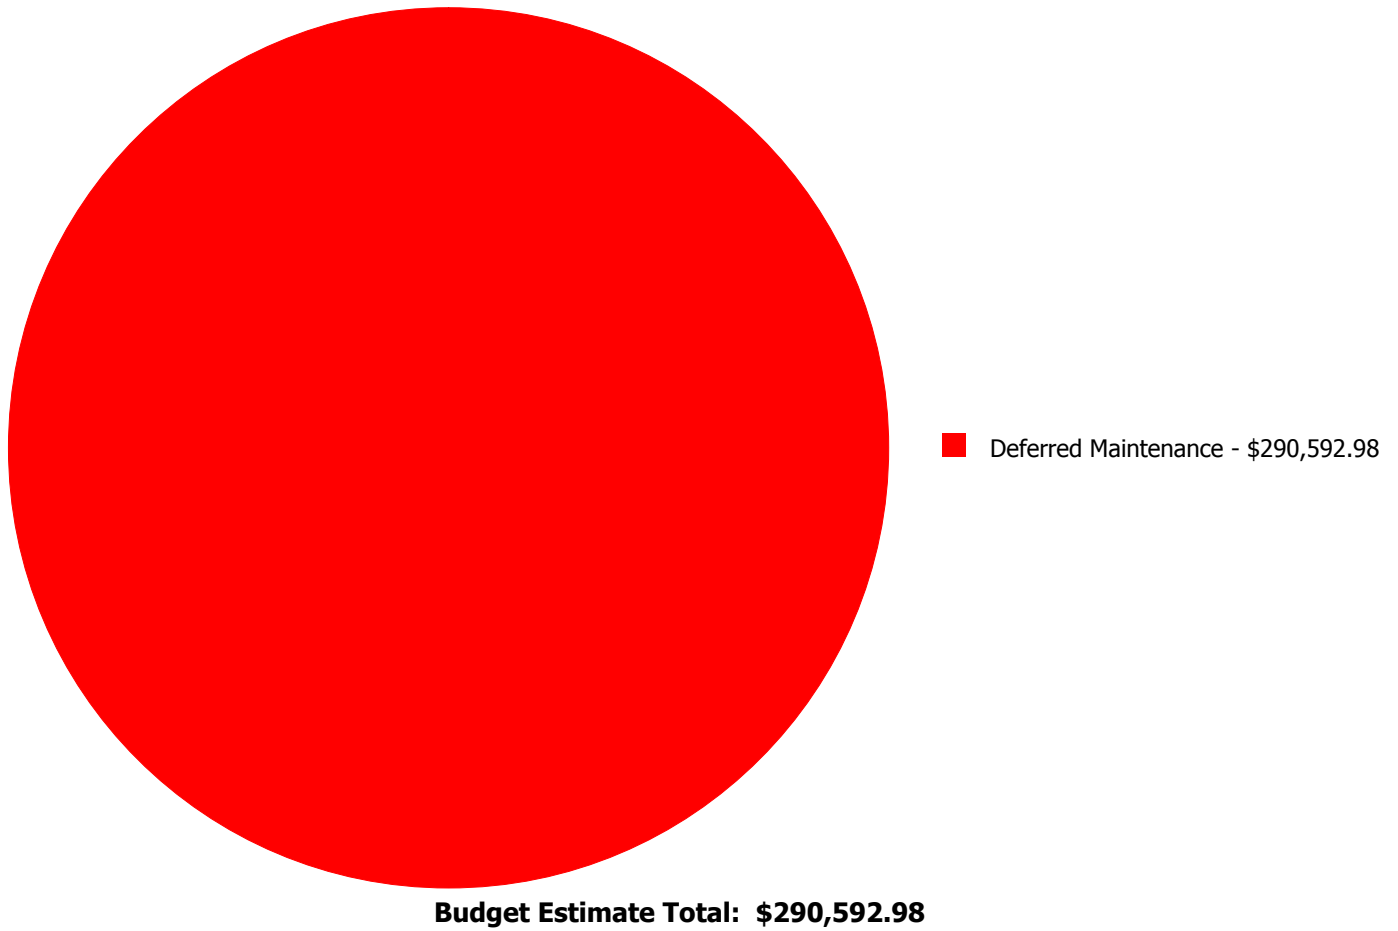
## Deficiency Summary by Category

The following chart shows the total repair costs broken down by deficiency categories. Assessors assigned deficiencies to one of the following categories:

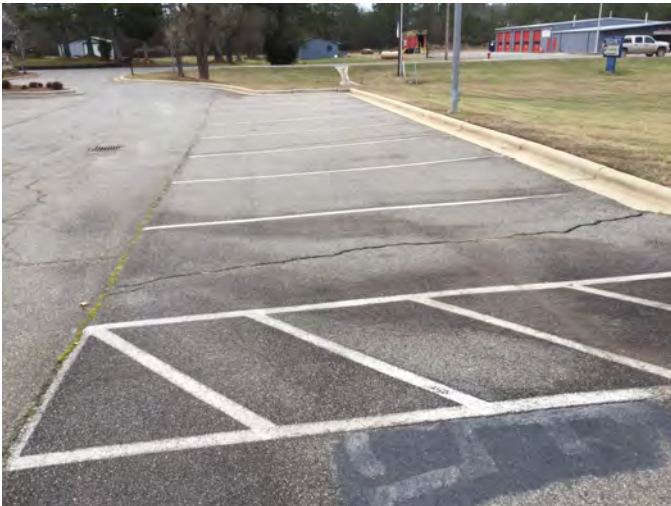
#### System: G2020 - Parking Lots

**Location:** Site  
**Distress:** Inadequate  
**Category:** Deferred Maintenance  
**Priority:** 3 - Necessary/Not Yet Critical (Years 2-5)  
**Correction:** Parking lot repair and sealcoating  
**Qty:** 120.00  
**Unit of Measure:** M.S.F.  
**Estimate:** \$99,734.98  
**Assessor Name:** Eduardo Lopez  
**Date Created:** 01/18/2017

**Notes:** The parking area striping is in poor condition and needs to be restriped, and the parking area needs to be seal coated.

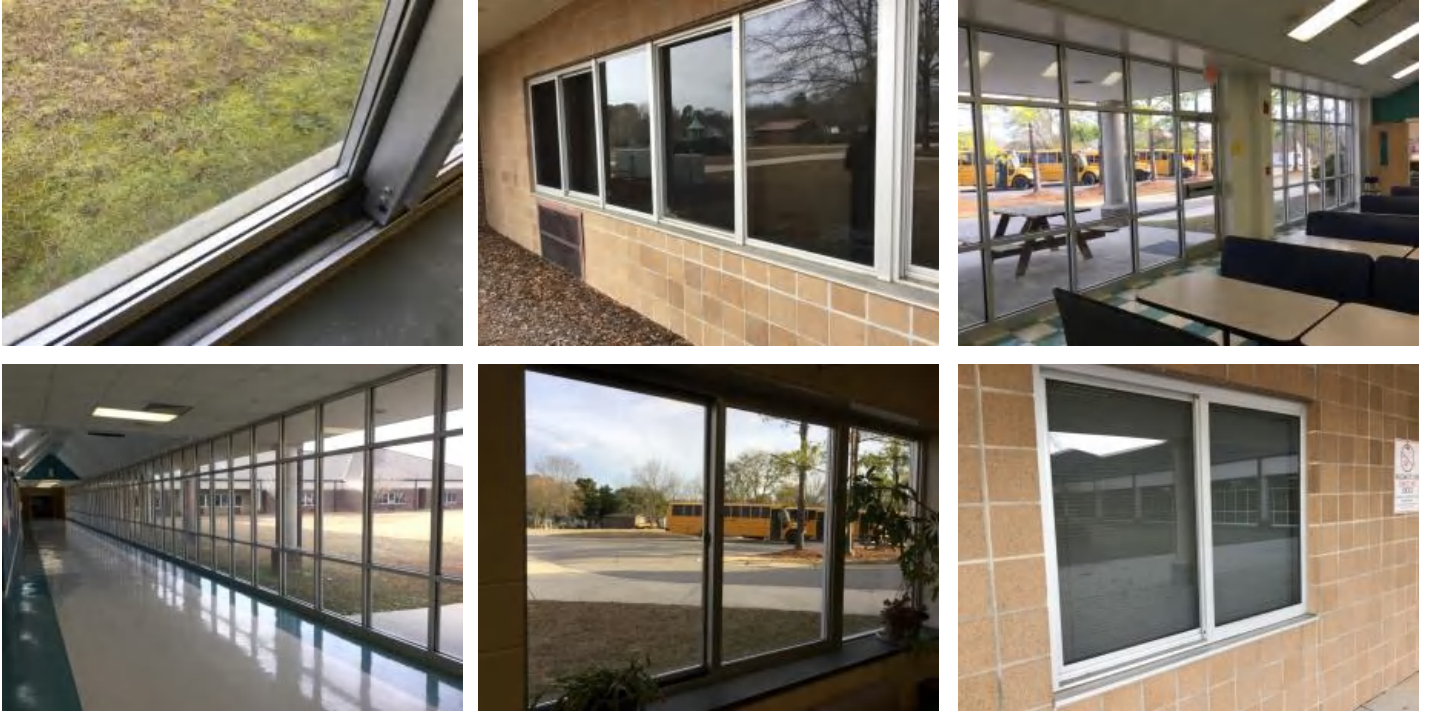
### System: B2020 - Exterior Windows

**Note:** When system expires and is scheduled for renewal, consider reducing window area by infilling with insulated exterior wall system to improve energy efficiency of the building.

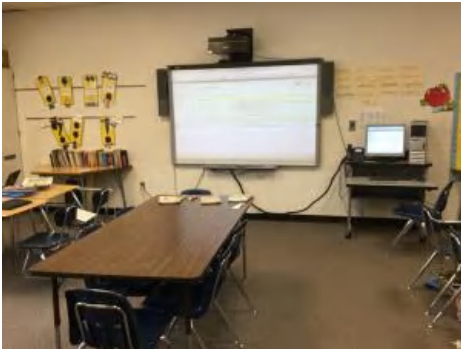
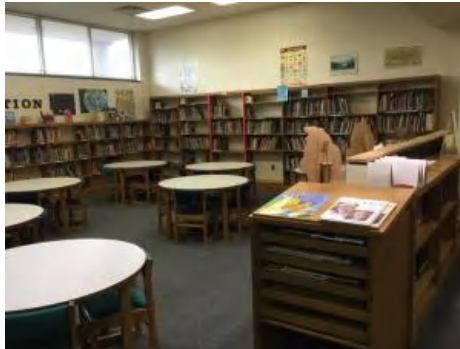
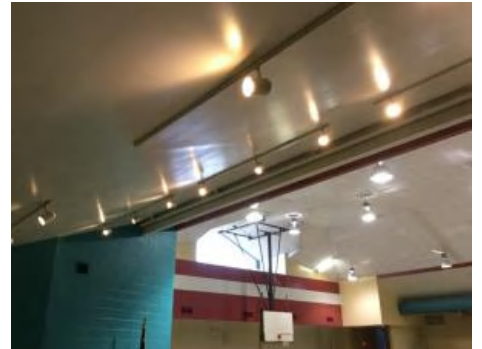
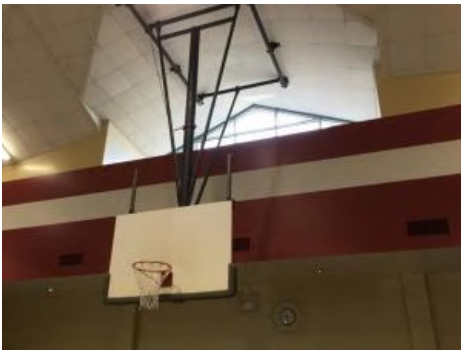
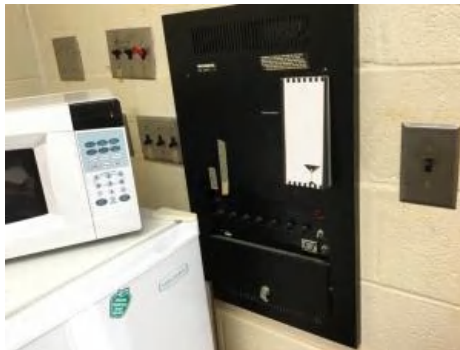
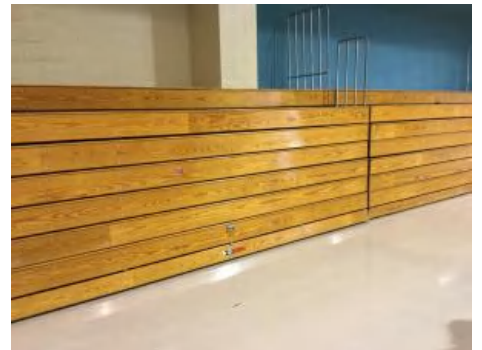
**System:** E1020 - Institutional Equipment

**Note:** Some newer equipment is installed. Original equipment is functional. System renewal date pushed to reflect no immediate need for replacements/upgrades.

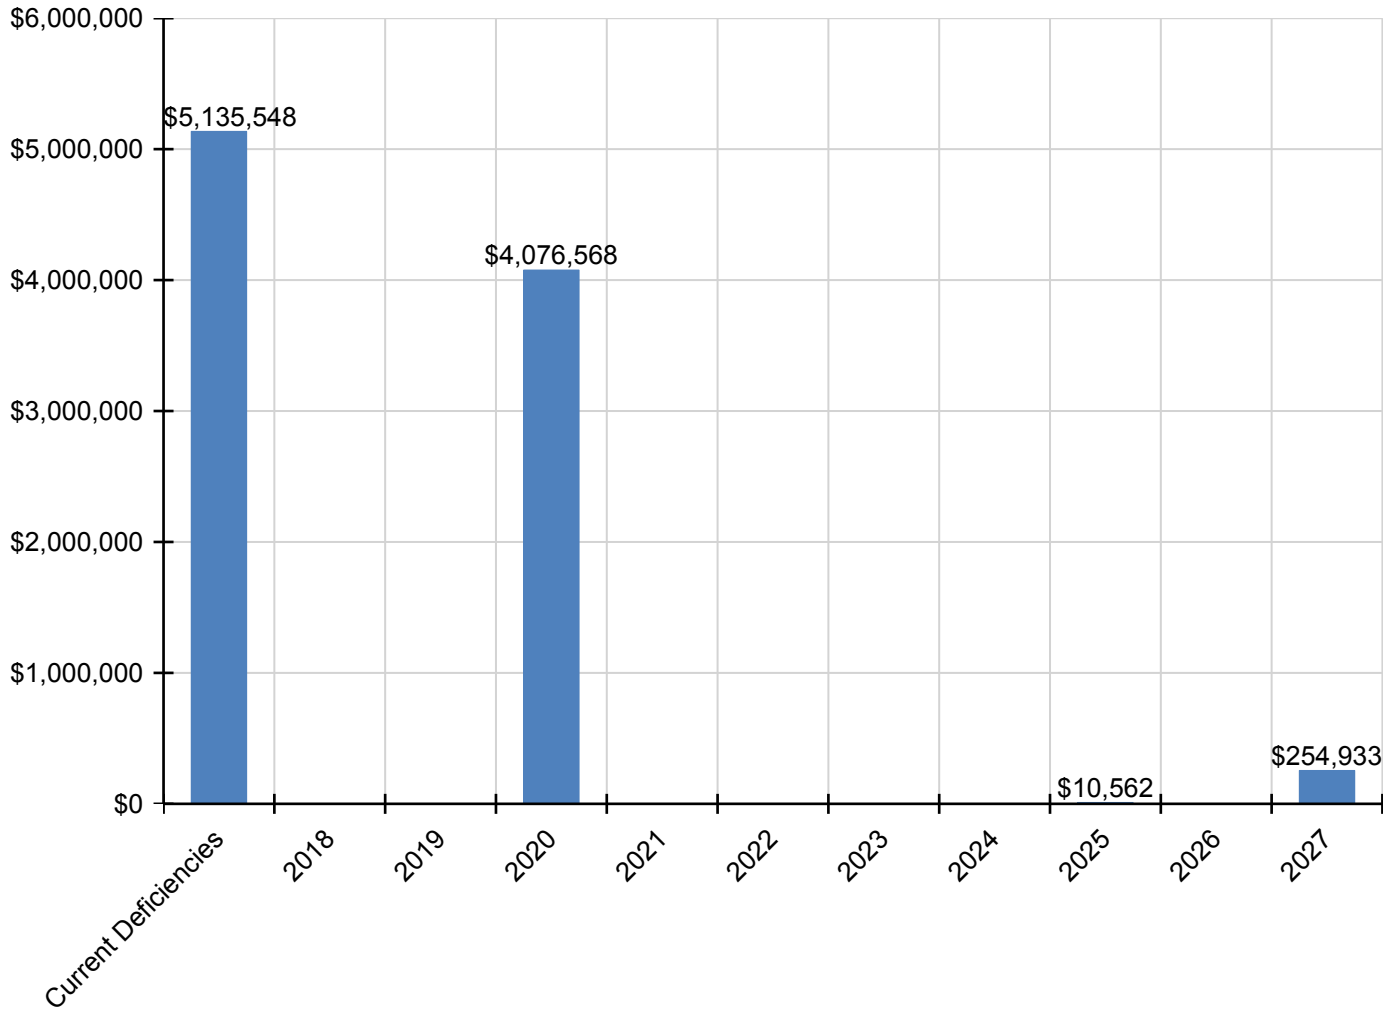
## Forecasted Capital Renewal Requirement

The following chart shows the current building deficiencies and forecasting capital renewal or sustainment requirements over the next ten years.

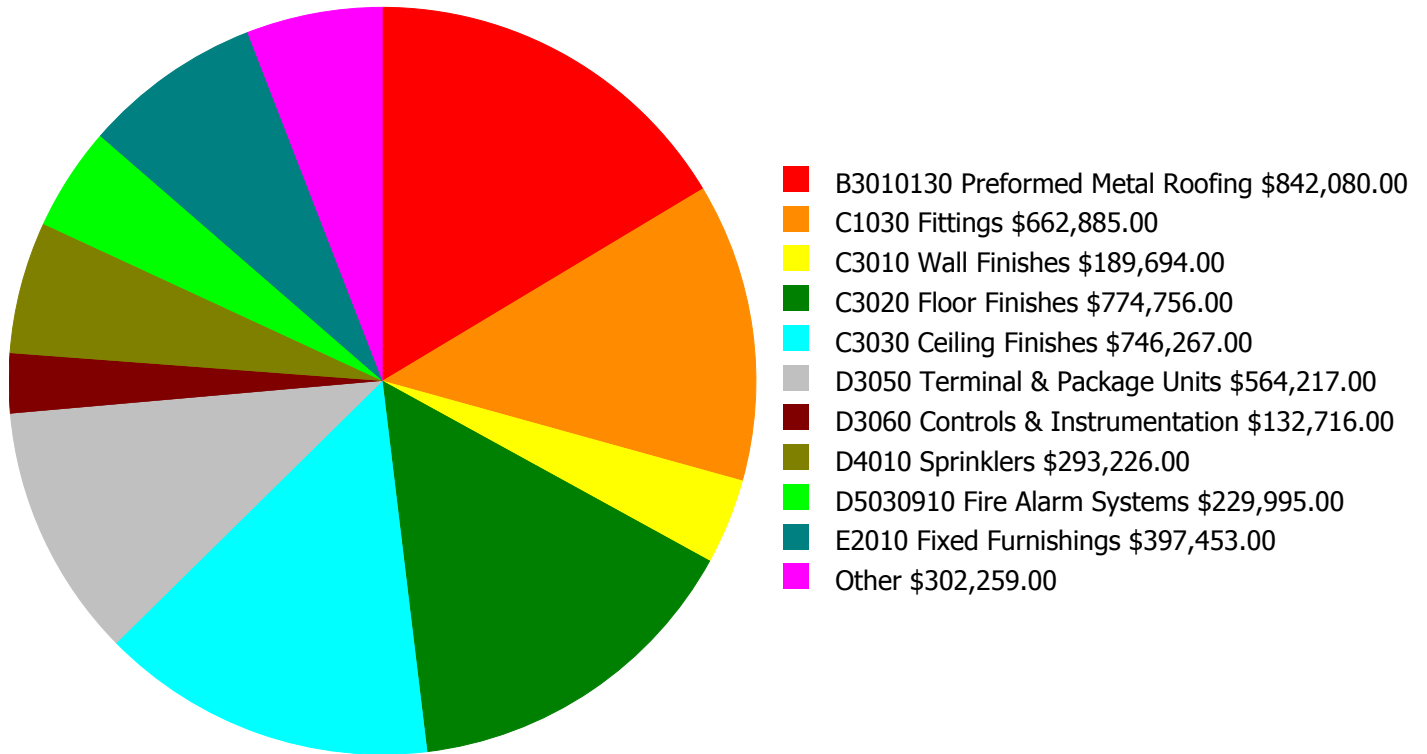
### Deficiency Summary by System

Current deficiencies included assemblies that have reached or exceeded their design life or components of the assemblies that are in need of repair. Assemblies that have reached their design life are identified as current deficiencies and assigned the distress 'Beyond Useful Life'. The following chart lists all current deficiencies associated with this facility.

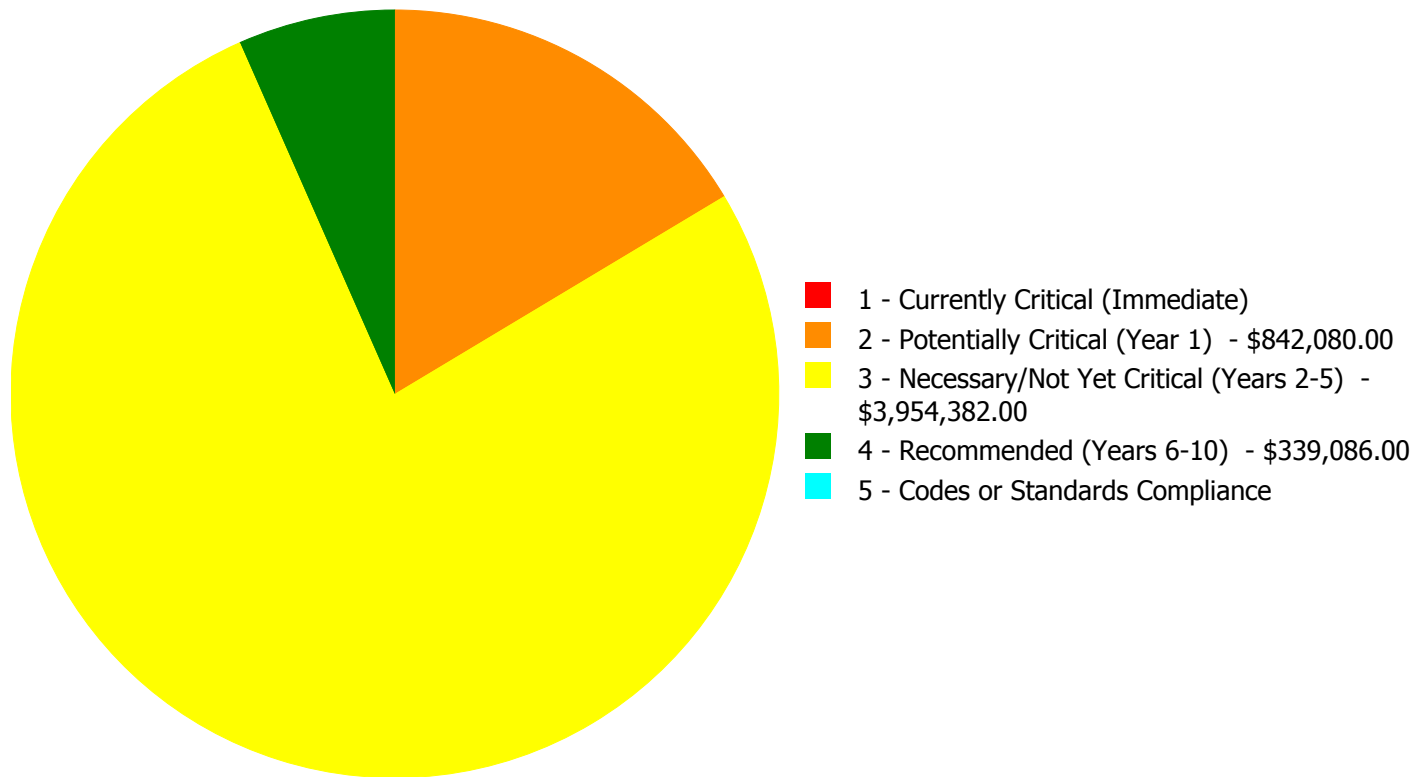
### Deficiency Summary by Priority

The following chart shows the total repair costs broken down by priority. Assessors assigned deficiencies within eCOMET to one of the following priority categories:

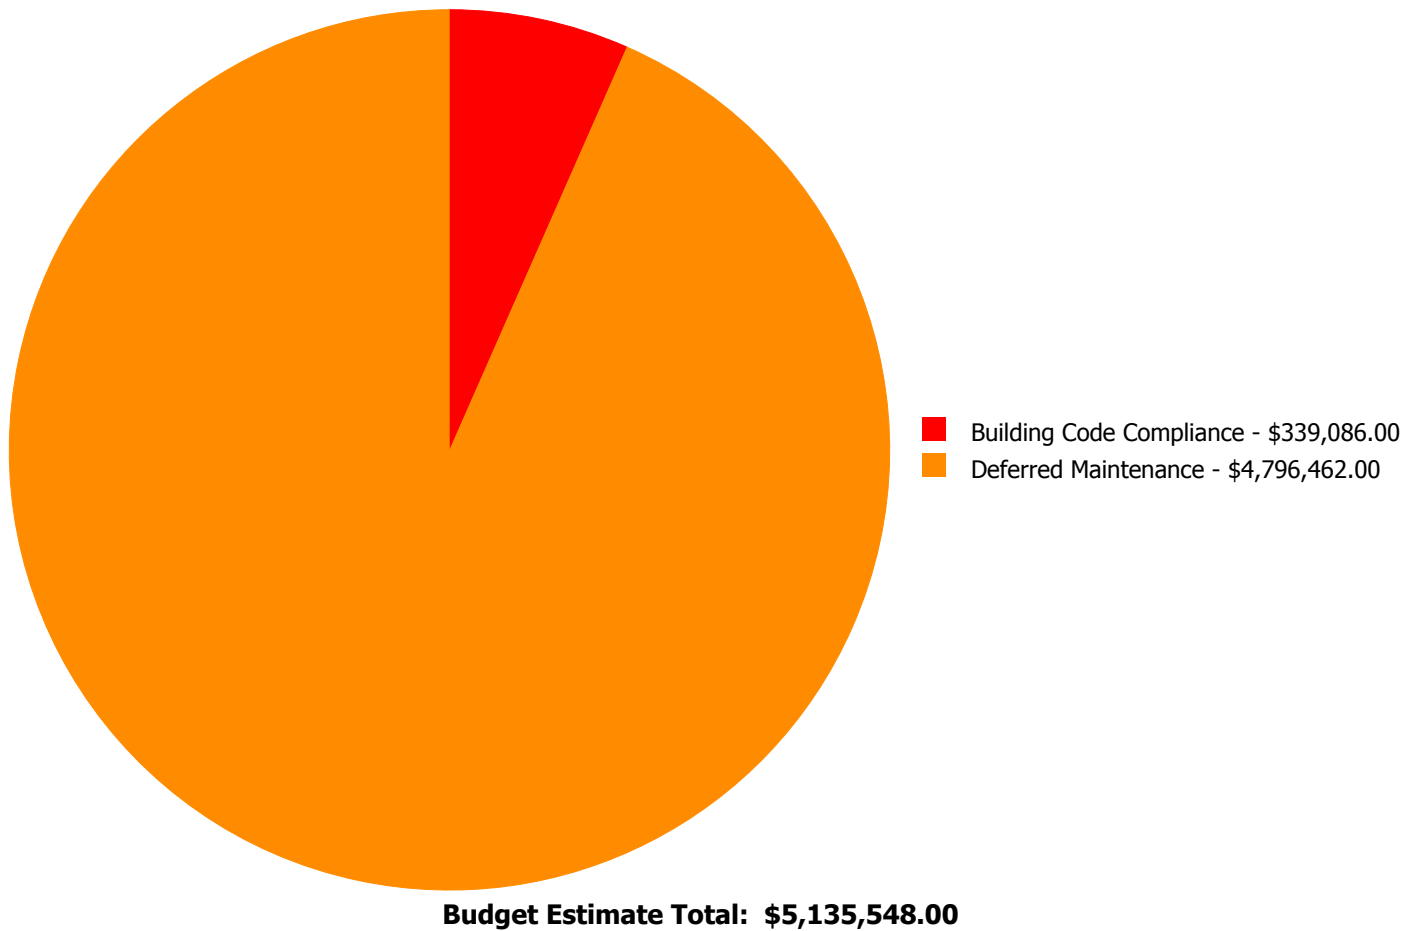
## Deficiency Summary by Category

The following chart shows the total repair costs broken down by deficiency categories. Assessors assigned deficiencies to one of the following categories:

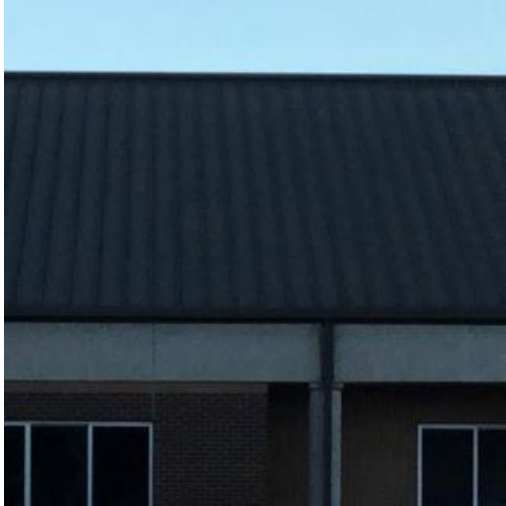
#### **System: B3010130 - Preformed Metal Roofing**

**Location:** Roof  
**Distress:** Failing  
**Category:** Deferred Maintenance  
**Priority:** 2 - Potentially Critical (Year 1)  
**Correction:** Renew System  
**Qty:** 63,168.00  
**Unit of Measure:** S.F.  
**Estimate:** \$842,080.00  
**Assessor Name:** Eduardo Lopez  
**Date Created:** 02/09/2017

**Notes:** Despite major repairs in 2014, roofs continue to leak, particularly in wind driven conditions around ridge vents. As a result water damaged ceiling tile replacement is a continual maintenance task. Gutters are in poor condition. Consider proper ventilation and insulation in redesign to mitigate humidity problems. System redesign and replacement is recommended.

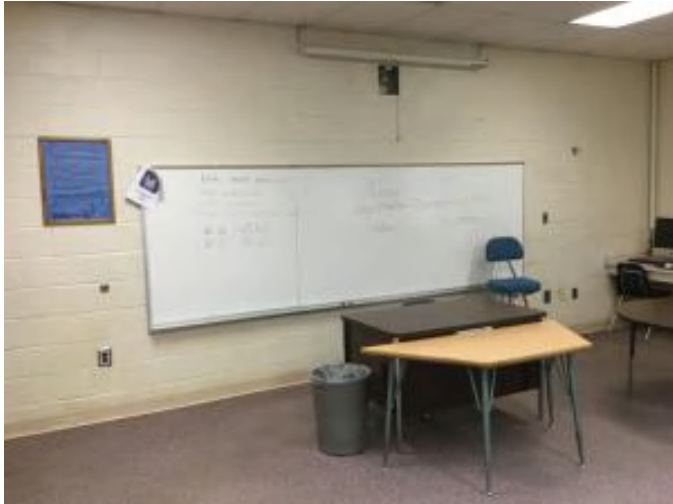
**System: C1030 - Fittings**

**Location:** Throughout the building  
**Distress:** Beyond Service Life  
**Category:** Deferred Maintenance  
**Priority:** 3 - Necessary/Not Yet Critical (Years 2-5)  
**Correction:** Renew System  
**Qty:** 63,168.00  
**Unit of Measure:** S.F.  
**Estimate:** \$662,885.00  
**Assessor Name:** Eduardo Lopez  
**Date Created:** 12/16/2016

**Notes:** Building fittings are typically original and beyond their expected life. Whiteboards in particular are noted by district staff to be in need of replacement. System renewal is recommended.

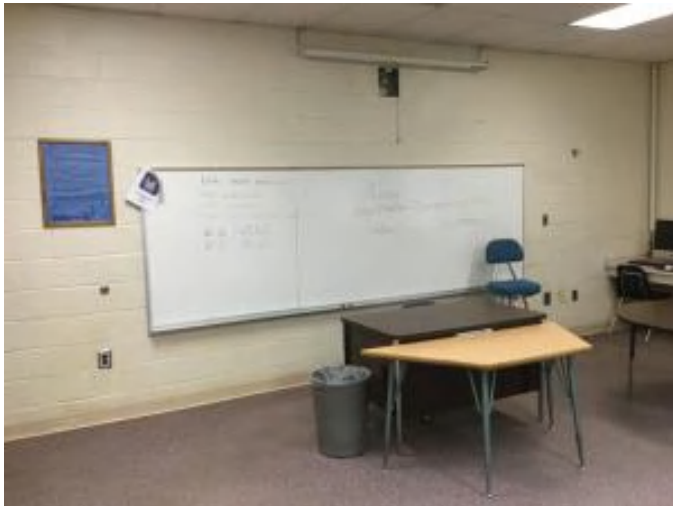
**System: C3010 - Wall Finishes**

**Location:** Throughout the building  
**Distress:** Beyond Service Life  
**Category:** Deferred Maintenance  
**Priority:** 3 - Necessary/Not Yet Critical (Years 2-5)  
**Correction:** Renew System  
**Qty:** 63,168.00  
**Unit of Measure:** S.F.  
**Estimate:** \$189,694.00  
**Assessor Name:** Eduardo Lopez  
**Date Created:** 12/16/2016

**Notes:** A comprehensive painting program is not implemented in this building. Repainting throughout is recommended.

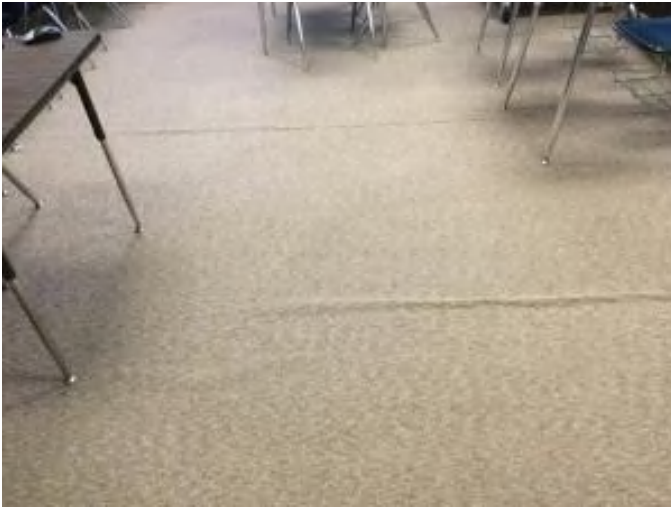
**System: C3020 - Floor Finishes**

**Location:** Throughout the building  
**Distress:** Beyond Service Life  
**Category:** Deferred Maintenance  
**Priority:** 3 - Necessary/Not Yet Critical (Years 2-5)  
**Correction:** Renew System  
**Qty:** 63,168.00  
**Unit of Measure:** S.F.  
**Estimate:** \$774,756.00  
**Assessor Name:** Eduardo Lopez  
**Date Created:** 12/16/2016

**Notes:** While some classrooms have had carpet replaced with VCT, there is still a considerable amount of carpet in poor condition in classrooms. Original VCT is generally beyond its expected useful life. System renewal is recommended.

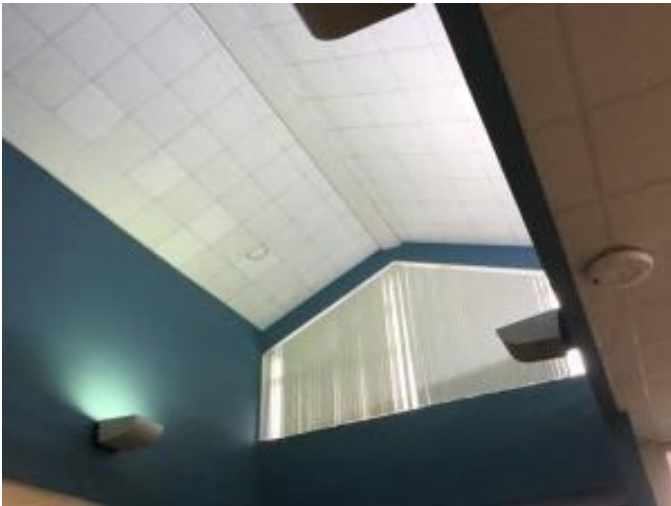
**System: C3030 - Ceiling Finishes**

**Location:** Throughout the building  
**Distress:** Beyond Service Life  
**Category:** Deferred Maintenance  
**Priority:** 3 - Necessary/Not Yet Critical (Years 2-5)  
**Correction:** Renew System  
**Qty:** 63,168.00  
**Unit of Measure:** S.F.  
**Estimate:** \$746,267.00  
**Assessor Name:** Eduardo Lopez  
**Date Created:** 12/16/2016

**Notes:** Although well maintained without broken or missing tile, ceilings are in aged condition. Frequent tile replacements due to roof leaks and condensation have resulted in mismatched tile throughout the building. Grids are starting to yellow. It is recommended that system renewal follow roof replacement.

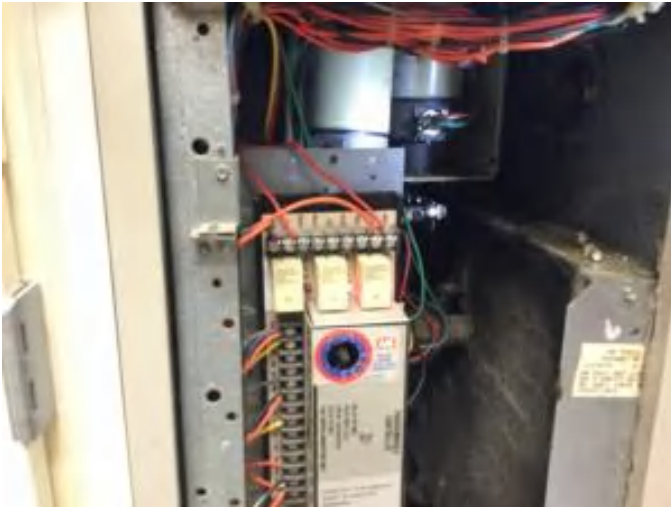
**System: D3050 - Terminal & Package Units**

**Location:** Throughout the building  
**Distress:** Beyond Service Life  
**Category:** Deferred Maintenance  
**Priority:** 3 - Necessary/Not Yet Critical (Years 2-5)  
**Correction:** Renew System  
**Qty:** 63,168.00  
**Unit of Measure:** S.F.  
**Estimate:** \$564,217.00  
**Assessor Name:** Eduardo Lopez  
**Date Created:** 12/16/2016

**Notes:** Terminal and package units, mostly ground mounted condensers for the split systems and cabinet unit ventilators with compressors, have exceeded their expected useful life. Parts for the unit ventilators are difficult to obtain and valves are not functioning. Outside air dampers do not function correctly. Refrigeration lines to newer ground mount units are poorly routed. System renewal is recommended.

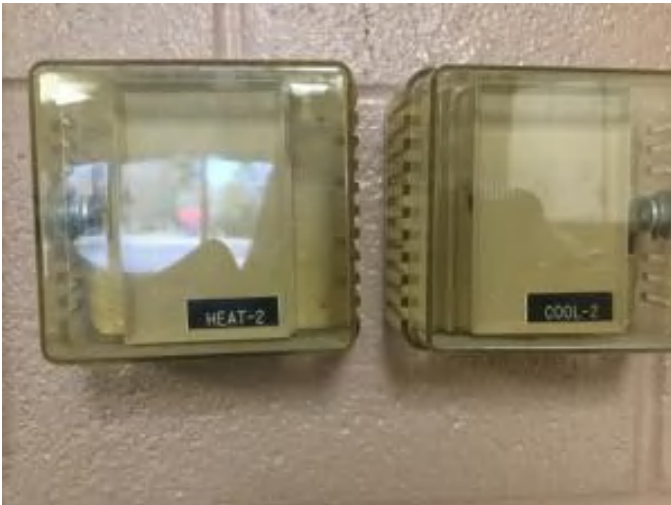
**System: D3060 - Controls & Instrumentation**

**Location:** Throughout the building  
**Distress:** Beyond Service Life  
**Category:** Deferred Maintenance  
**Priority:** 3 - Necessary/Not Yet Critical (Years 2-5)  
**Correction:** Renew System  
**Qty:** 63,168.00  
**Unit of Measure:** S.F.  
**Estimate:** \$132,716.00  
**Assessor Name:** Eduardo Lopez  
**Date Created:** 12/16/2016

**Notes:** Building controls are typically original pneumatics. They are locally controlled. Installation of a modern digital system with remote monitoring and control capability for energy conservation is recommended.

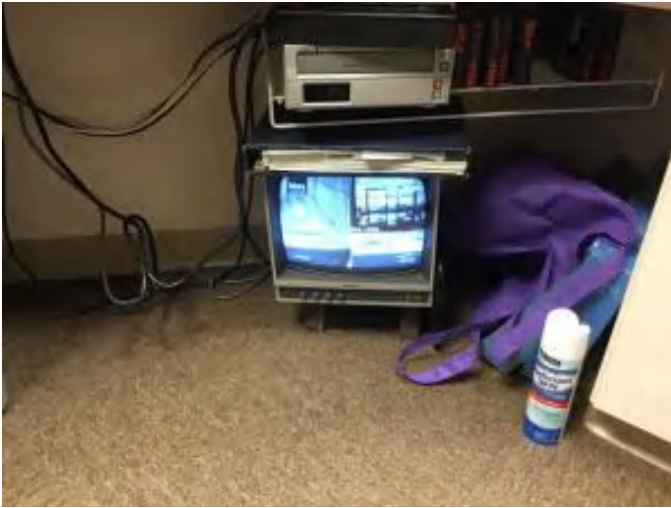
**System: D5030810 - Security & Detection Systems**

**Location:** Throughout the building  
**Distress:** Beyond Service Life  
**Category:** Deferred Maintenance  
**Priority:** 3 - Necessary/Not Yet Critical (Years 2-5)  
**Correction:** Renew System  
**Qty:** 63,168.00  
**Unit of Measure:** S.F.  
**Estimate:** \$127,157.00  
**Assessor Name:** Eduardo Lopez  
**Date Created:** 12/16/2016

**Notes:** The security system is mostly original and beyond its expected life. There are areas inside and outside the building that aren't monitored. System renewal is recommended.

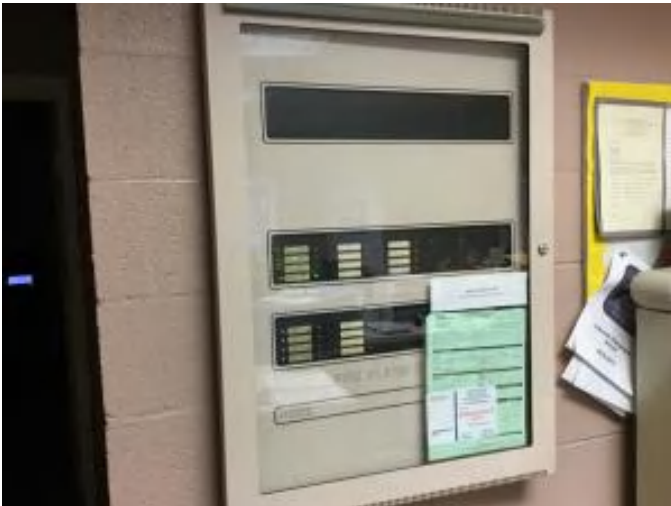
**System: D5030910 - Fire Alarm Systems**

**Location:** Throughout the building  
**Distress:** Beyond Service Life  
**Category:** Deferred Maintenance  
**Priority:** 3 - Necessary/Not Yet Critical (Years 2-5)  
**Correction:** Renew System  
**Qty:** 63,168.00  
**Unit of Measure:** S.F.  
**Estimate:** \$229,995.00  
**Assessor Name:** Eduardo Lopez  
**Date Created:** 12/16/2016

**Notes:** The fire alarm system is original and beyond its expected life. System renewal is recommended to ensure reliability of this life safety system.

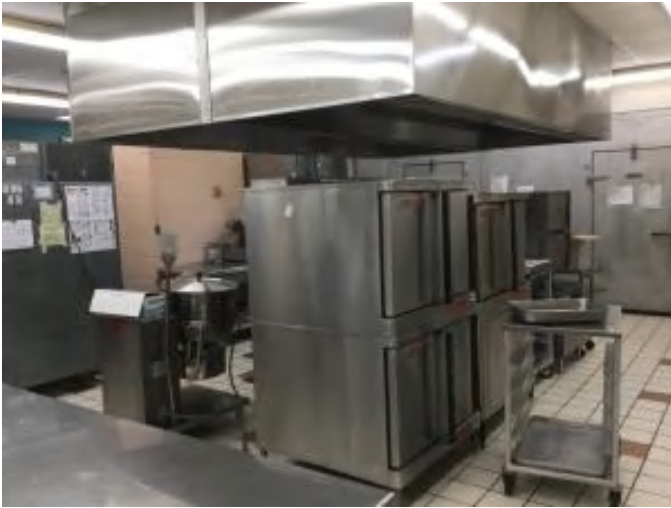
**System: E1090 - Other Equipment**

**Location:** Kitchen  
**Distress:** Beyond Service Life  
**Category:** Deferred Maintenance  
**Priority:** 3 - Necessary/Not Yet Critical (Years 2-5)  
**Correction:** Renew System  
**Qty:** 63,168.00  
**Unit of Measure:** S.F.  
**Estimate:** \$129,242.00  
**Assessor Name:** Eduardo Lopez  
**Date Created:** 12/16/2016

**Notes:** Kitchen equipment is typically original and beyond its expected life. System renewal is recommended.

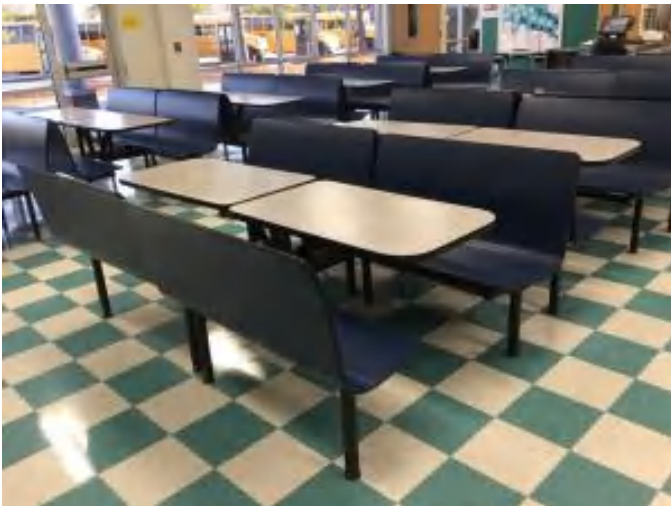
**System: E2010 - Fixed Furnishings**

**Location:** Classrooms, cafeteria.  
**Distress:** Beyond Service Life  
**Category:** Deferred Maintenance  
**Priority:** 3 - Necessary/Not Yet Critical (Years 2-5)  
**Correction:** Renew System  
**Qty:** 63,168.00  
**Unit of Measure:** S.F.  
**Estimate:** \$397,453.00  
**Assessor Name:** Eduardo Lopez  
**Date Created:** 12/16/2016

**Notes:** Interior furnishings are beyond their expected life and are showing signs of wear and tear. Most classrooms do not have window blinds. System renewal is recommended.

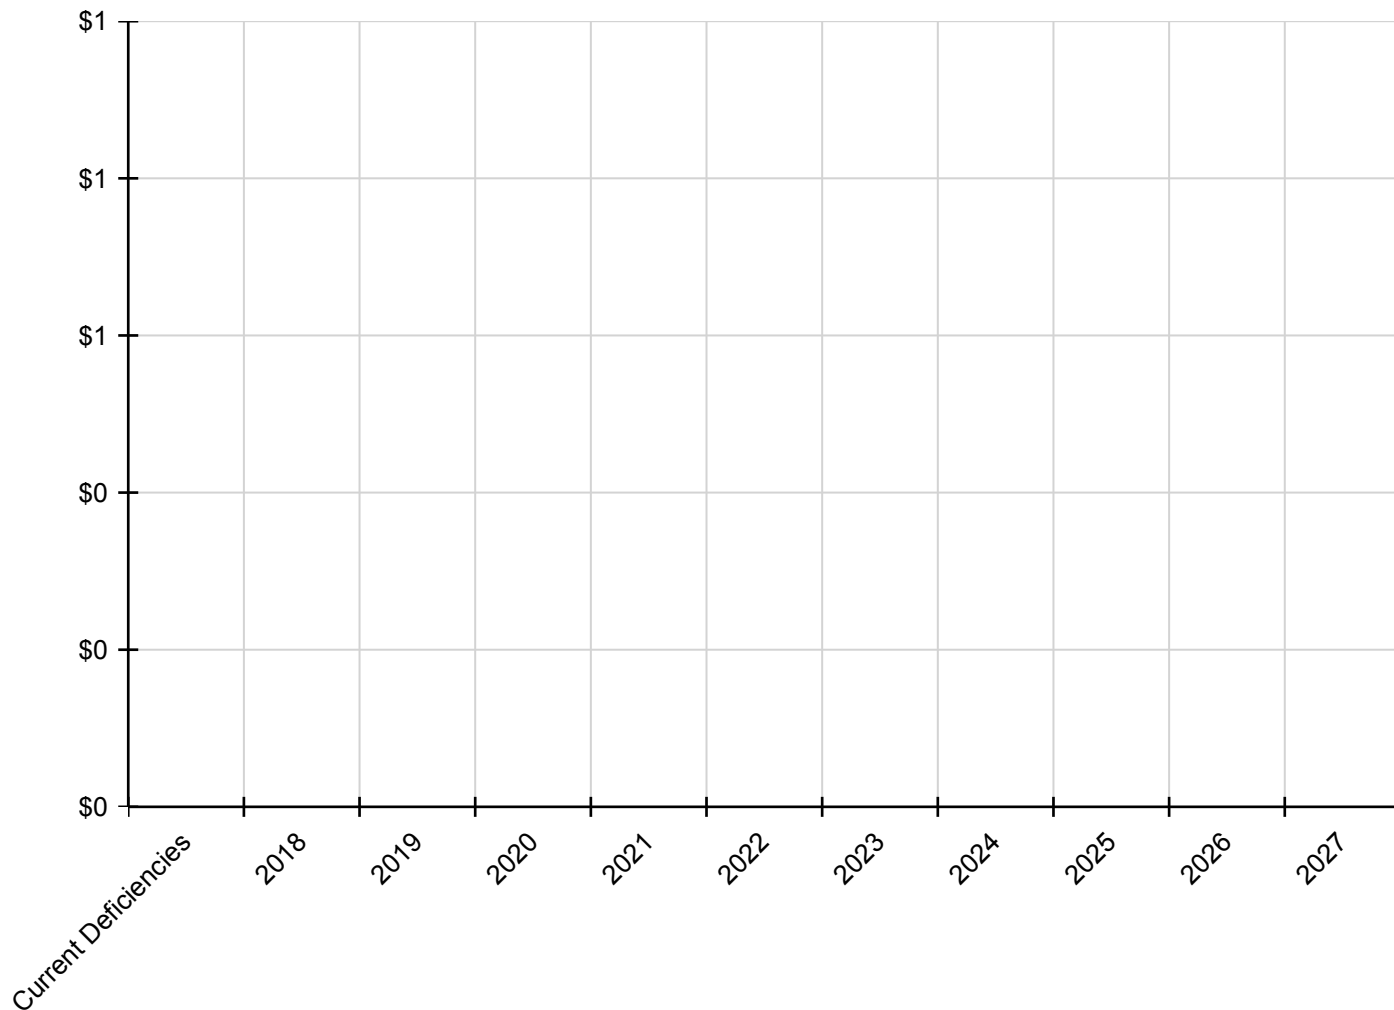
The following chart shows the current building deficiencies and forecasting capital renewal or sustainment requirements over the next ten years.

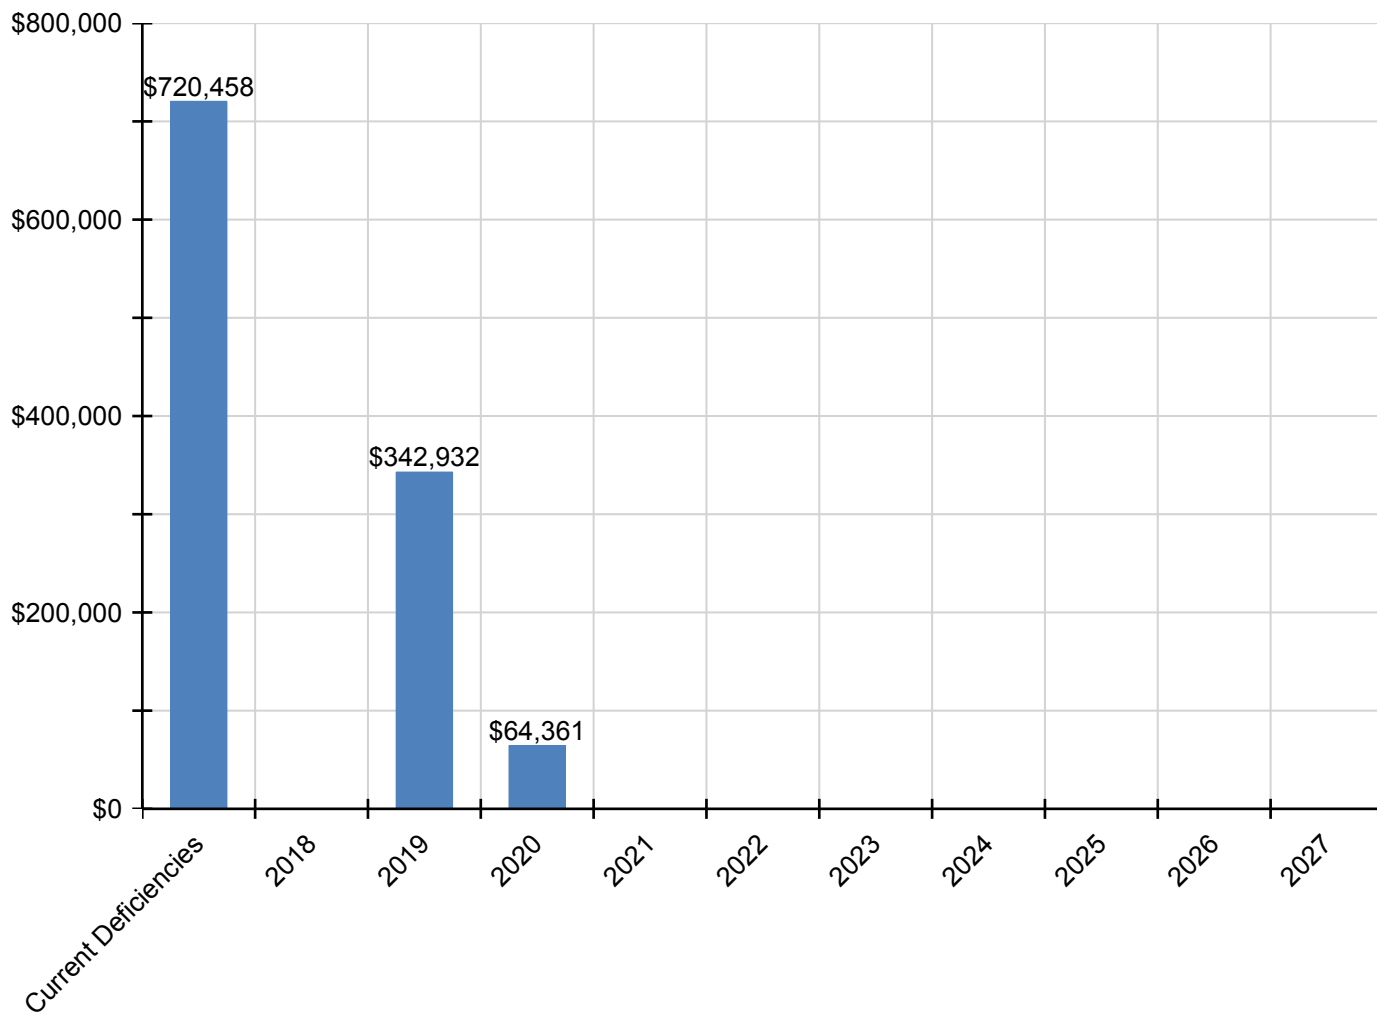
## Forecasted Capital Renewal Requirement

The following chart shows the current building deficiencies and forecasting capital renewal or sustainment requirements over the next ten years.

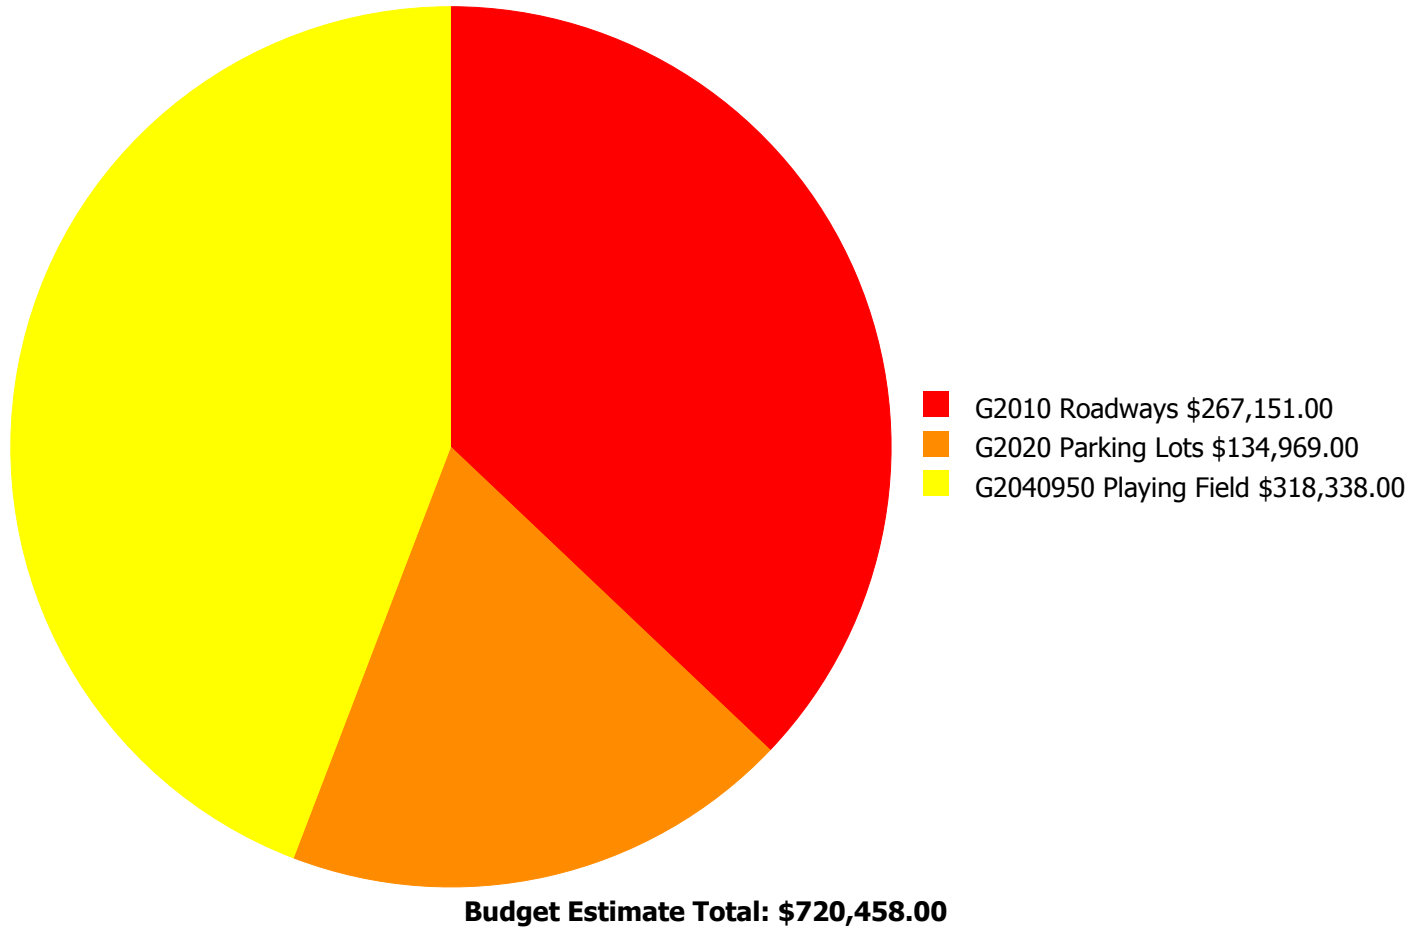
## Deficiency Summary by System

Current deficiencies included assemblies that have reached or exceeded their design life or components of the assemblies that are in need of repair. Assemblies that have reached their design life are identified as current deficiencies and assigned the distress 'Beyond Useful Life'. The following chart lists all current deficiencies associated with this facility.

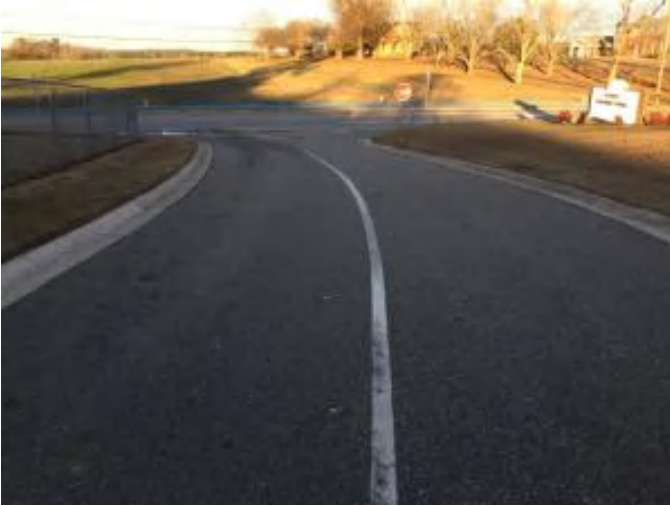
#### System: G2010 - Roadways

**Location:** Site  
**Distress:** Beyond Service Life  
**Category:** Deferred Maintenance  
**Priority:** 3 - Necessary/Not Yet Critical (Years 2-5)  
**Correction:** Renew System  
**Qty:** 63,744.00  
**Unit of Measure:** S.F.  
**Estimate:** \$267,151.00  
**Assessor Name:** Ann Buerger Linden  
**Date Created:** 02/22/2017

**Notes:** Roadways are in fair condition with a grainy texture and some cracking beginning. System renewal is recommended.

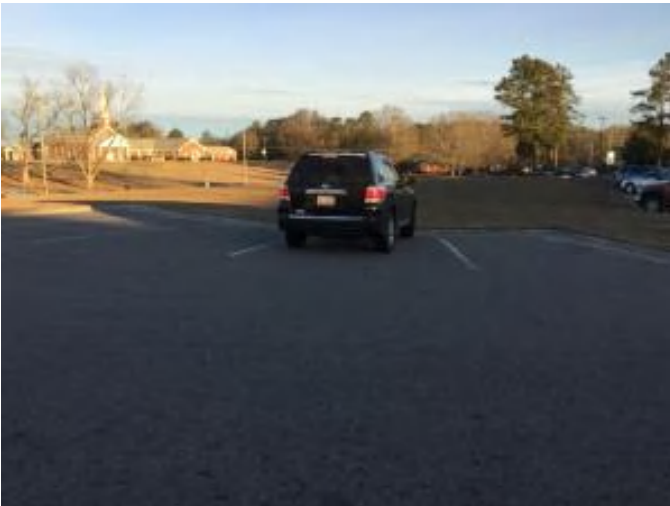
#### System: G2020 - Parking Lots

**Location:** Parking lots  
**Distress:** Beyond Service Life  
**Category:** Deferred Maintenance  
**Priority:** 3 - Necessary/Not Yet Critical (Years 2-5)  
**Correction:** Renew System  
**Qty:** 63,744.00  
**Unit of Measure:** S.F.  
**Estimate:** \$93,257.00  
**Assessor Name:** Ann Buerger Linden  
**Date Created:** 02/22/2017

**Notes:** The parking lot is aged, has a grainy surface and striping is faded. There is some cracking of the surface. Handicap signs markings need to meet ADA standards.

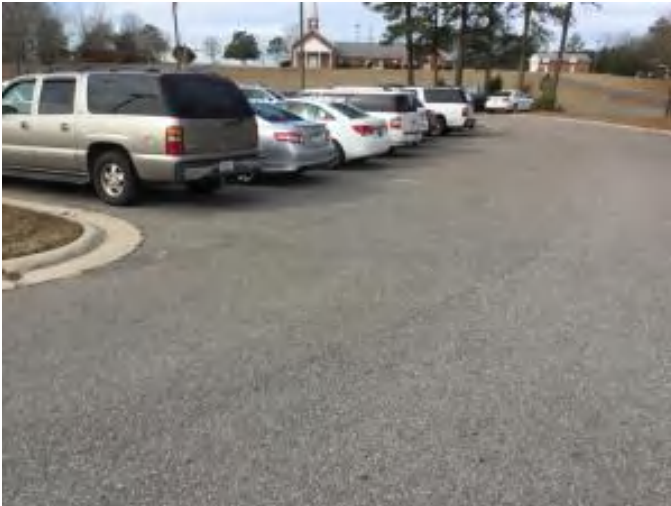
**System: G2020 - Parking Lots**

**Location:** Site  
**Distress:** Inadequate  
**Category:** Safety  
**Priority:** 3 - Necessary/Not Yet Critical (Years 2-5)  
**Correction:** Add more parking spaces  
**Qty:** 20.00  
**Unit of Measure:** Ea.  
**Estimate:** \$41,712.00  
**Assessor Name:** Ann Buerger Linden  
**Date Created:** 02/09/2017

**Notes:** The number of parking spaces for staff and visitors is inadequate for the school size. Construction of additional parking spaces is recommended.

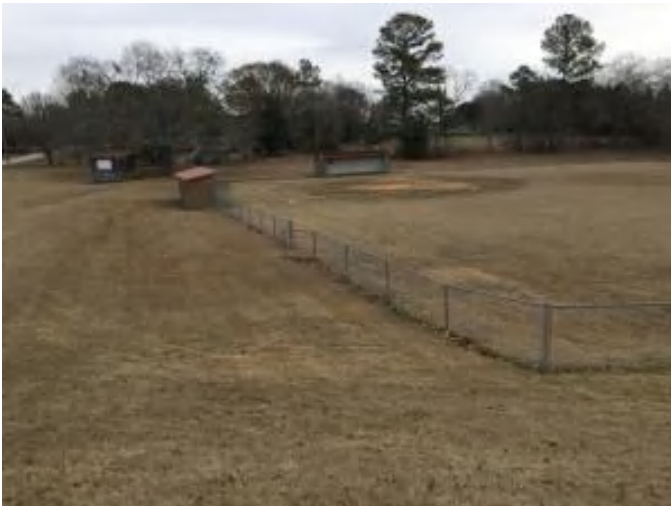
**System: G2040950 - Playing Field**

**Location:** East end of site  
**Distress:** Beyond Service Life  
**Category:** Deferred Maintenance  
**Priority:** 3 - Necessary/Not Yet Critical (Years 2-5)  
**Correction:** Renew System  
**Qty:** 63,744.00  
**Unit of Measure:** S.F.  
**Estimate:** \$318,338.00  
**Assessor Name:** Ann Buerger Linden  
**Date Created:** 02/22/2017

**Notes:** The playing field is original and in need of updates. System renewal is recommended.

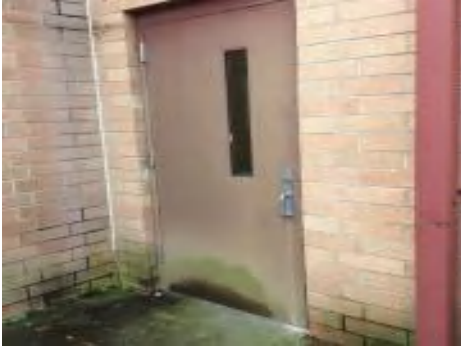
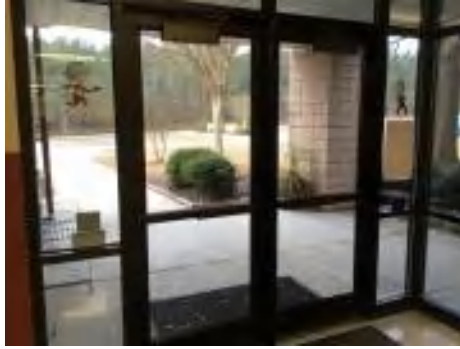
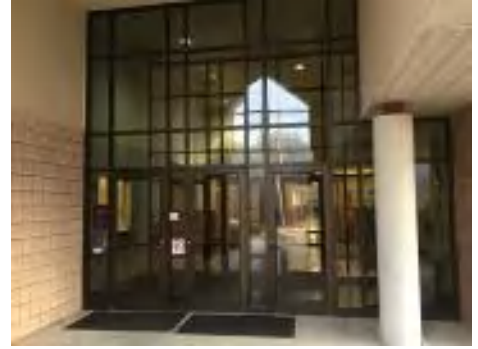
**System:** B2030 - Exterior Doors

**Note:** Exterior doors are generally functional. Some maintenance repairs are required. System renewal at scheduled expiration is recommended.

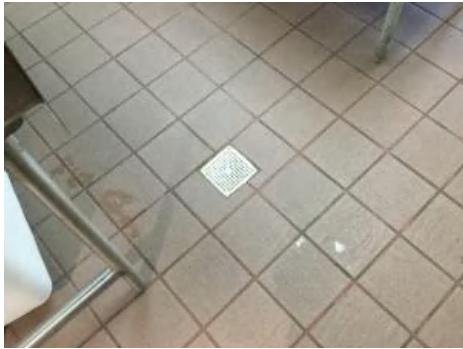
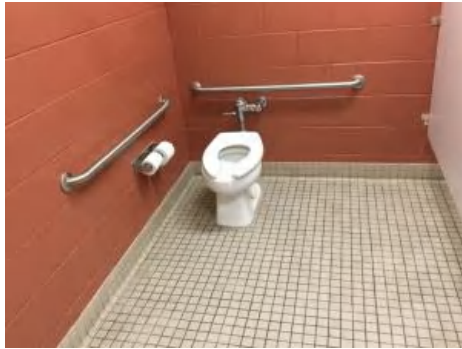
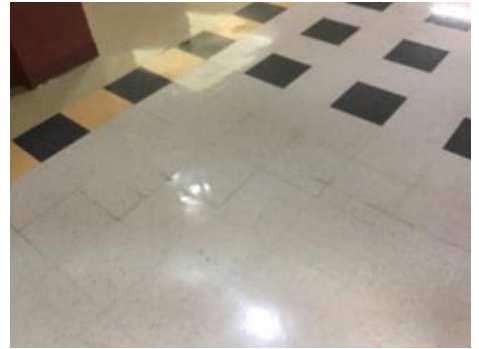
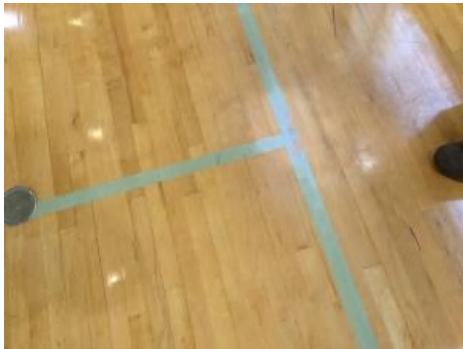
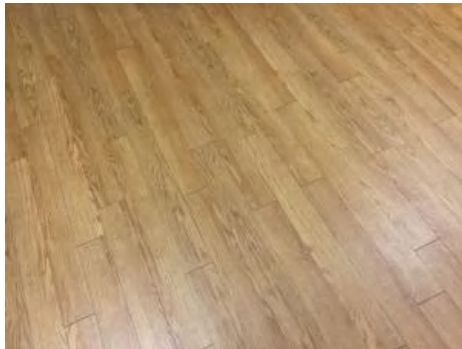
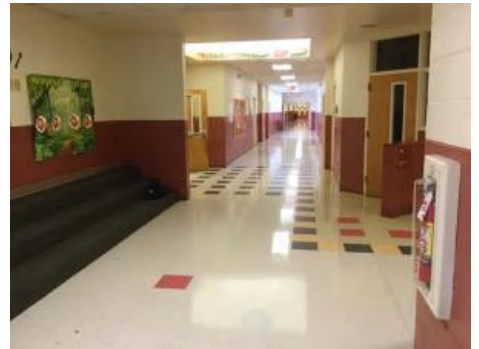
**System:** C3020 - Floor Finishes

**Note:** All carpet changed to VCT 2016.

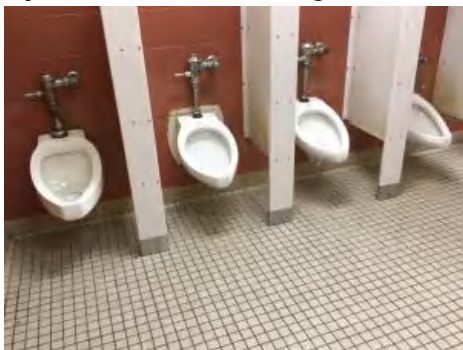
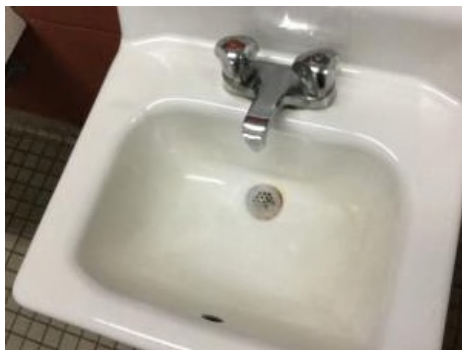
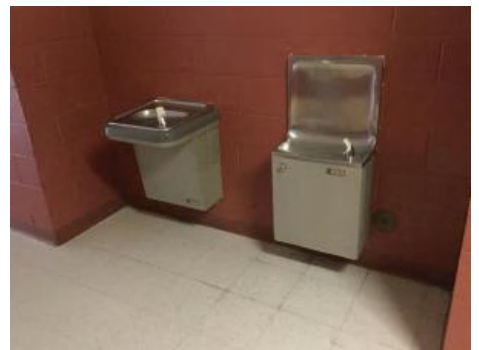
**System:** D2010 - Plumbing Fixtures

**Note:** System renewal at the scheduled 30 year time frame is recommended. Water heaters have been recently updated.
