# Anson Middle

## Campus Assessment Report

March 7, 2017

## Campus Assessment Report - 1966 Building, Cafe/Gym

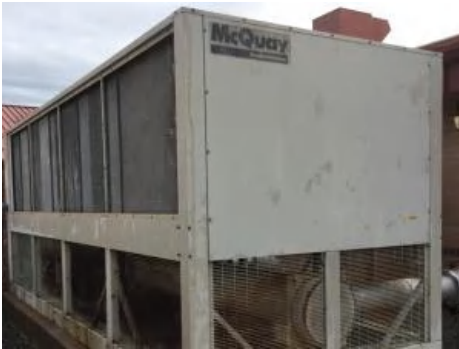
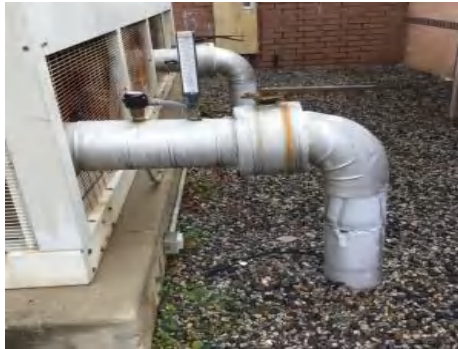
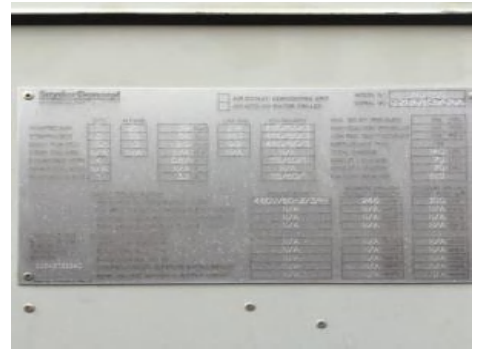
## System: D3030 - Cooling Generating Systems

**Note:** System will expire within one year of FCA. Chiller replacement is recommended along with other recommended HVAC replacements/upgrades for a complete system renovation.

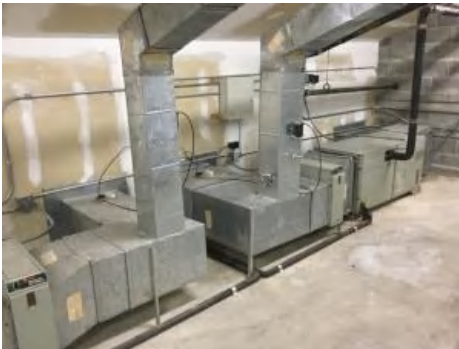
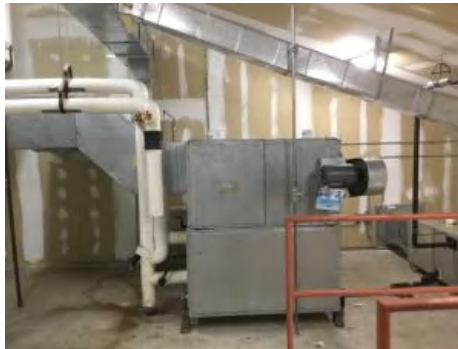
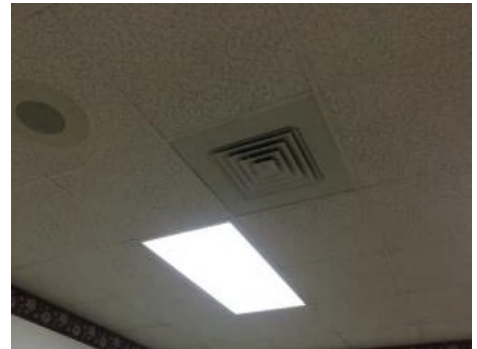
## System: D3040 - Distribution Systems

**Note:** Internally insulated ductwork.

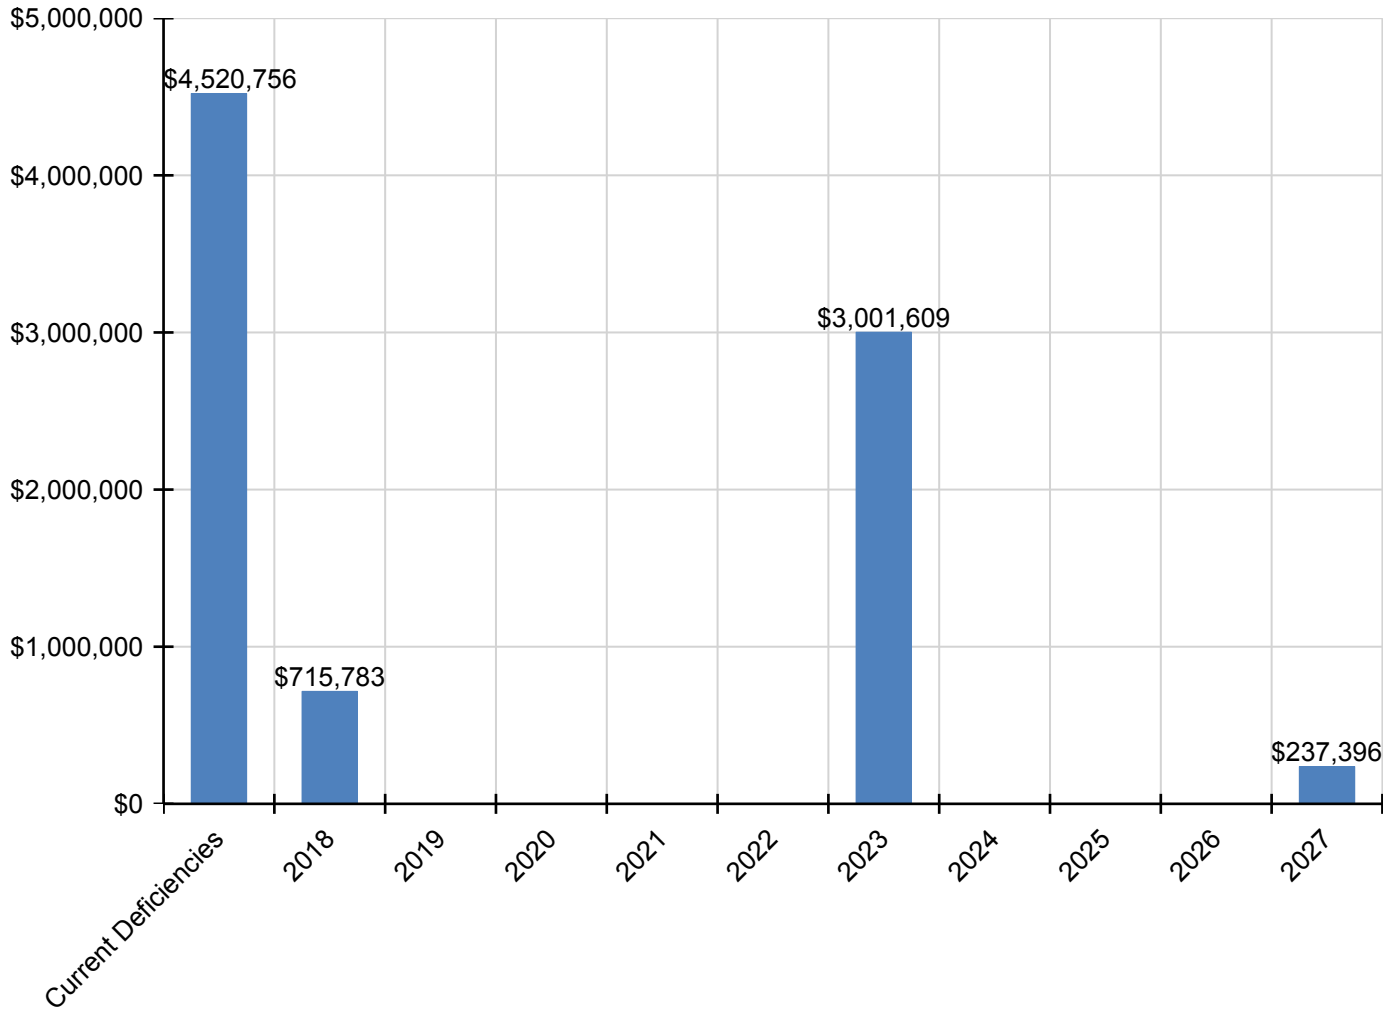
## Forecasted Capital Renewal Requirement

The following chart shows the current building deficiencies and forecasting capital renewal or sustainment requirements over the next ten years.

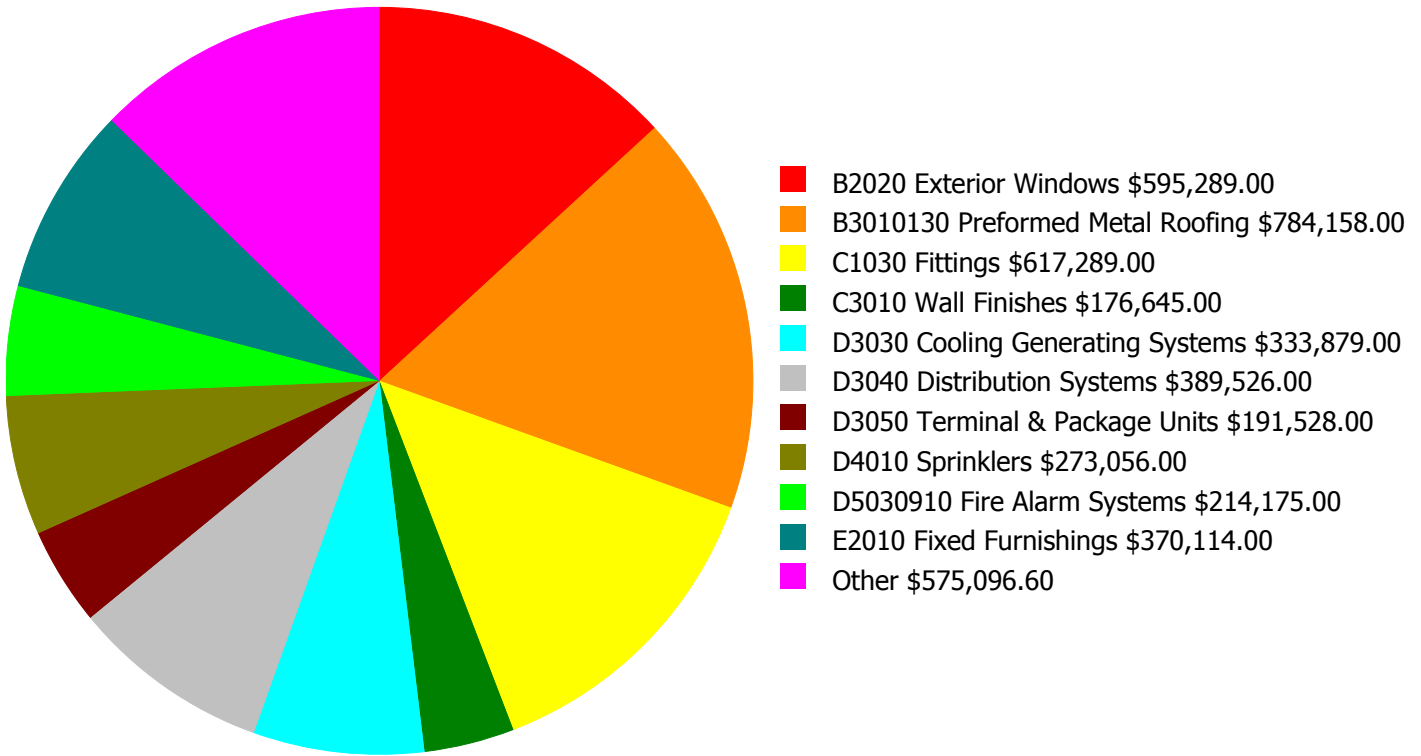
## Deficiency Summary by System

Current deficiencies included assemblies that have reached or exceeded their design life or components of the assemblies that are in need of repair. Assemblies that have reached their design life are identified as current deficiencies and assigned the distress 'Beyond Useful Life'. The following chart lists all current deficiencies associated with this facility.

**Budget Estimate Total: \$4,520,755.60**

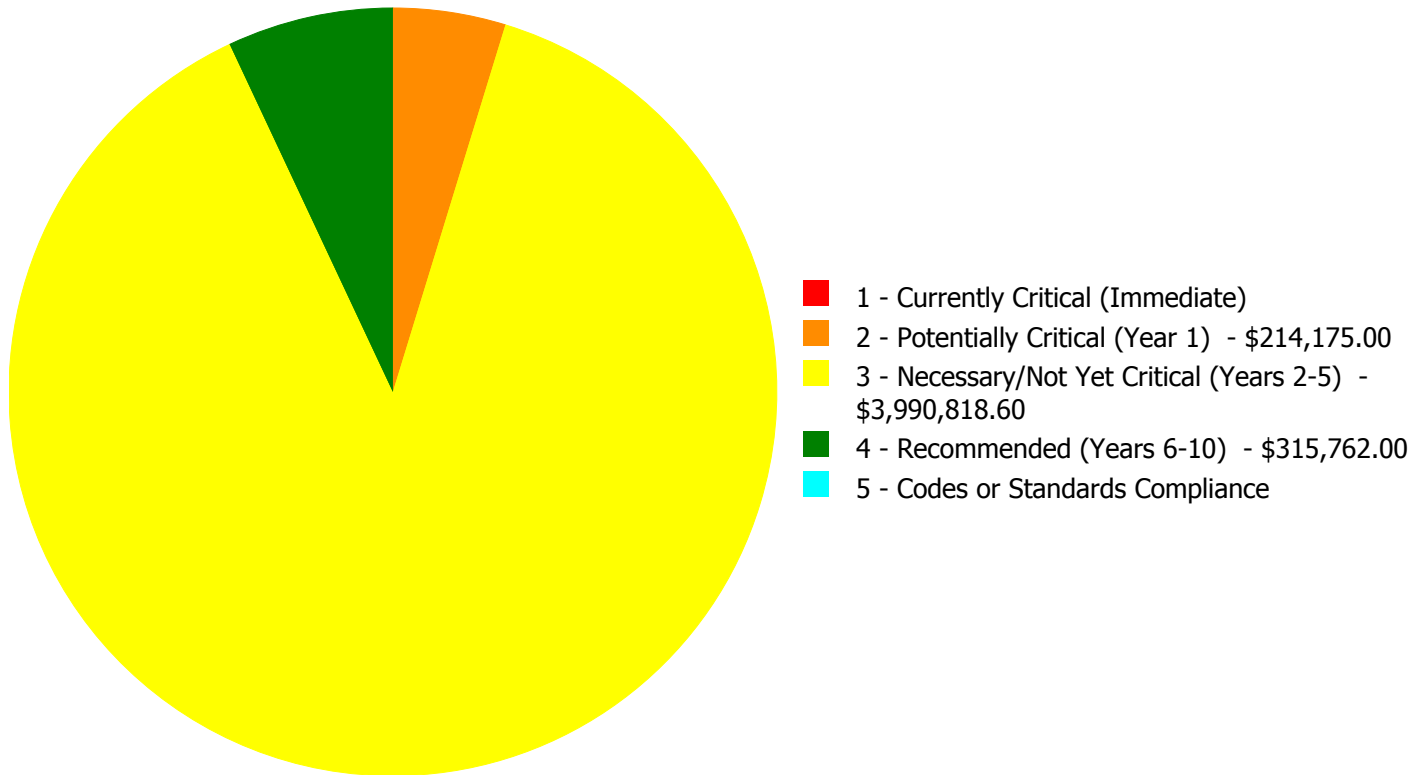
## Deficiency Summary by Priority

The following chart shows the total repair costs broken down by priority. Assessors assigned deficiencies within eCOMET to one of the following priority categories:

**Budget Estimate Total: \$4,520,755.60**

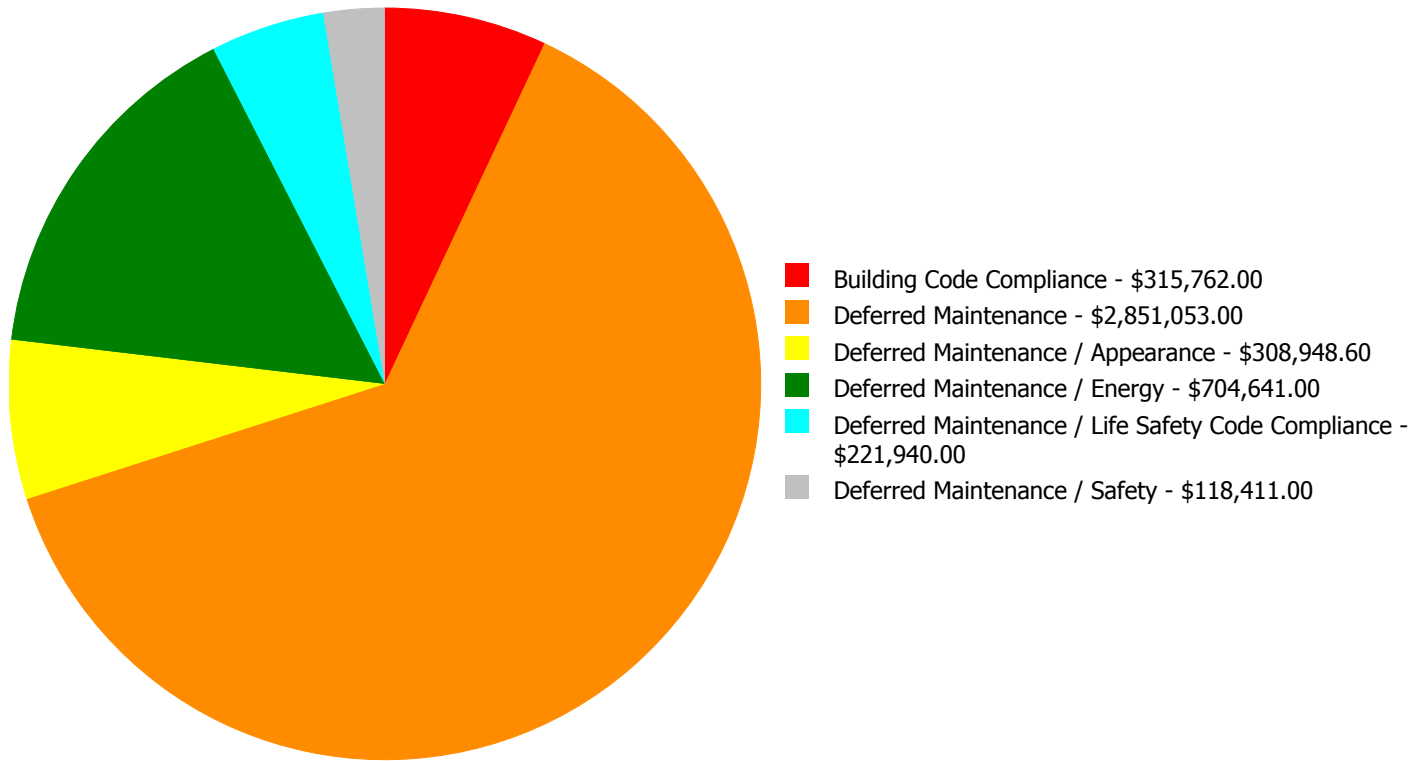
## Deficiency Summary by Category

The following chart shows the total repair costs broken down by deficiency categories. Assessors assigned deficiencies to one of the following categories:

**Budget Estimate Total: \$4,520,755.60**

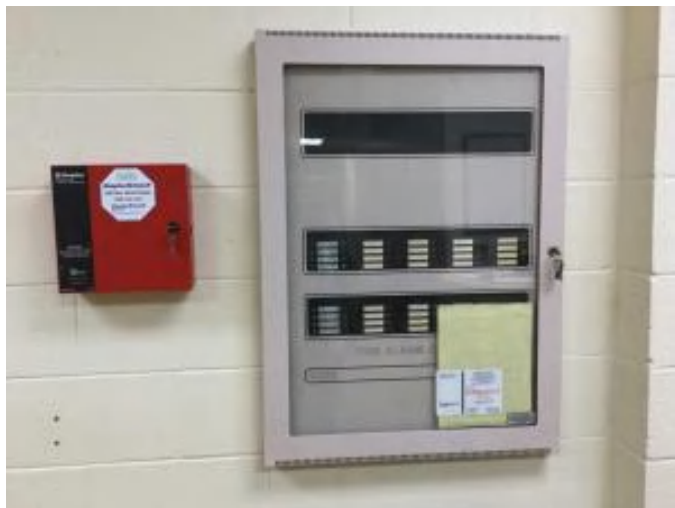
#### System: D5030910 - Fire Alarm Systems

**Location:** Throughout the building  
**Distress:** Failing  
**Category:** Deferred Maintenance / Life Safety Code Compliance  
**Priority:** 2 - Potentially Critical (Year 1)  
**Correction:** Renew System  
**Qty:** 58,823.00  
**Unit of Measure:** S.F.  
**Estimate:** \$214,175.00  
**Assessor Name:** Somnath Das  
**Date Created:** 01/09/2017

**Notes:** The fire alarm system is beyond its expected life. The system frequently has false alarms.

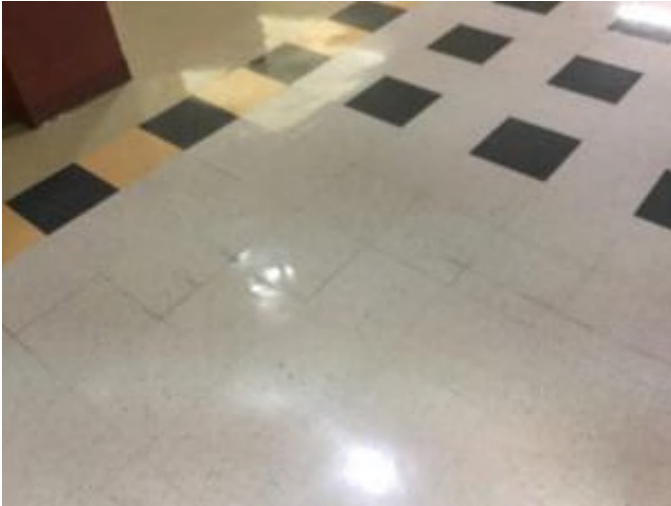
**System: A1010 - Standard Foundations**

**Location:** Throughout the school  
**Distress:** Damaged  
**Category:** Deferred Maintenance  
**Priority:** 3 - Necessary/Not Yet Critical (Years 2-5)  
**Correction:** Engineering Study  
**Qty:** 1.00  
**Unit of Measure:** Ea.  
**Estimate:** \$10,560.00  
**Assessor Name:** Somnath Das  
**Date Created:** 01/12/2017

**Notes:** Slabs on grade show some signs of minor separation; observed throughout the building. Some minor cracks in walls seen. An engineering study is recommended to determine the cause. Pricing does not include remediation measures.

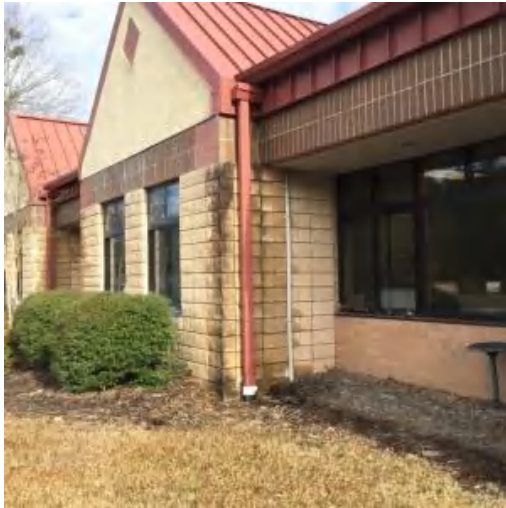
**System: B2010 - Exterior Walls**

**Location:** Exterior walls  
**Distress:** Damaged  
**Category:** Deferred Maintenance / Appearance  
**Priority:** 3 - Necessary/Not Yet Critical (Years 2-5)  
**Correction:** Spray refinish exterior walls  
**Qty:** 30,000.00  
**Unit of Measure:** S.F.  
**Estimate:** \$132,303.60  
**Assessor Name:** Somnath Das  
**Date Created:** 01/12/2017

**Notes:** Exterior walls are excessively stained, primarily due to roof/gutter conditions. Power washing of exterior walls is recommended to be scheduled after roof replacement is completed.

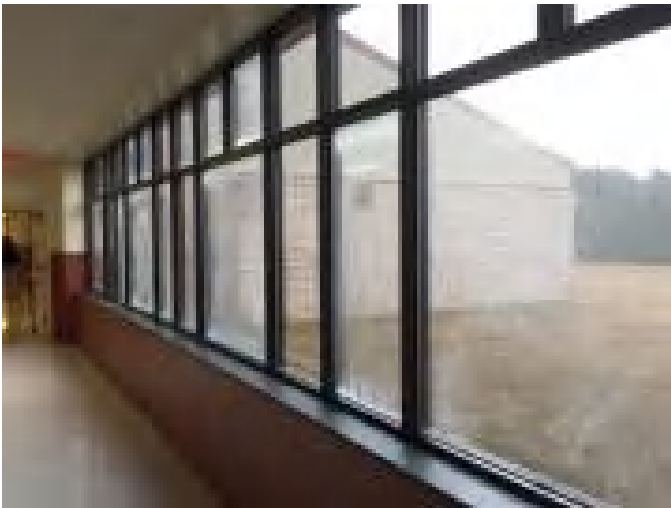
**System: B2020 - Exterior Windows**

**Location:** Exterior windows  
**Distress:** Failing  
**Category:** Deferred Maintenance  
**Priority:** 3 - Necessary/Not Yet Critical (Years 2-5)  
**Correction:** Renew System  
**Qty:** 58,823.00  
**Unit of Measure:** S.F.  
**Estimate:** \$595,289.00  
**Assessor Name:** Somnath Das  
**Date Created:** 01/11/2017

**Notes:** Exterior windows are failing prematurely throughout the school with loss of seals between dual panes. Operable windows (designated for emergency egress) are difficult to operate and may constitute a safety hazard in an evacuation situation. System renewal is recommended.

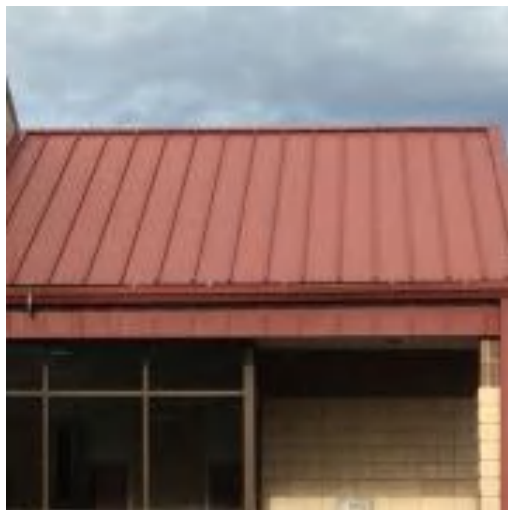
**System: B3010130 - Preformed Metal Roofing**

**Location:** Roof  
**Distress:** Failing  
**Category:** Deferred Maintenance  
**Priority:** 3 - Necessary/Not Yet Critical (Years 2-5)  
**Correction:** Renew System  
**Qty:** 58,823.00  
**Unit of Measure:** S.F.  
**Estimate:** \$784,158.00  
**Assessor Name:** Somnath Das  
**Date Created:** 01/11/2017

**Notes:** Metal roofing is leaking throughout the building, notably at the gym peak, but also in numerous other places, possibly due to faulty original design or installation. High maintenance costs for replacement of ceiling tile. The roof system is not adequately ventilated or insulated, resulting in moisture problems in the building. Gutters leak at seams, and are bent in many places due to ice. System replacement is recommended.

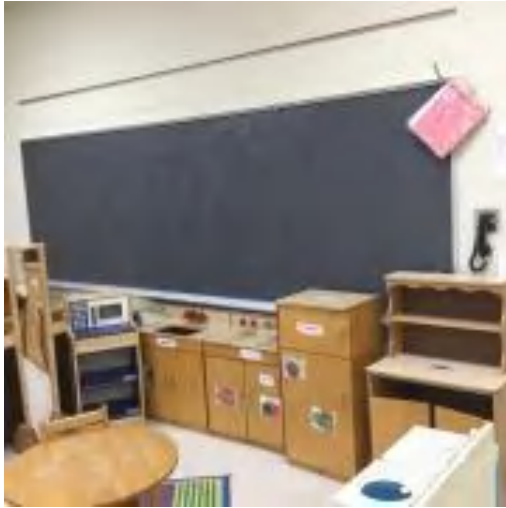
**System: C1030 - Fittings**

**Location:** Throughout the building  
**Distress:** Beyond Service Life  
**Category:** Deferred Maintenance  
**Priority:** 3 - Necessary/Not Yet Critical (Years 2-5)  
**Correction:** Renew System  
**Qty:** 58,823.00  
**Unit of Measure:** S.F.  
**Estimate:** \$617,289.00  
**Assessor Name:** Somnath Das  
**Date Created:** 01/09/2017

**Notes:** Building fittings are typically original and beyond their expected life. In particular, there are still some chalkboards in the school, and many whiteboards are stained beyond cleaning. Lockers at the kitchen are beginning to rust. Signage is original.

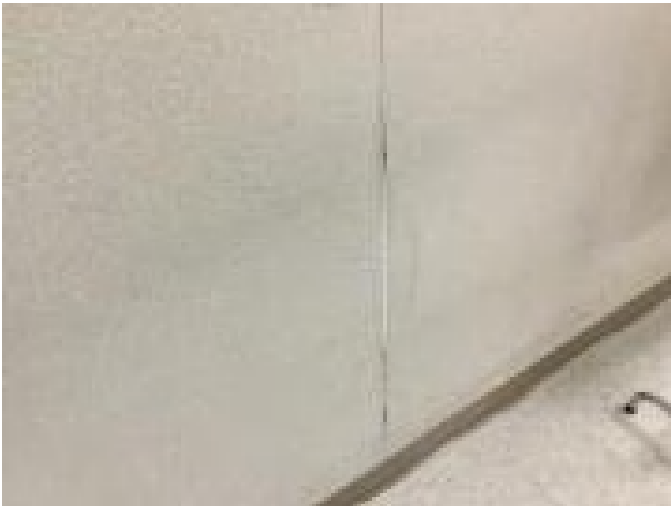
**System: C3010 - Wall Finishes**

**Location:** Throughout the building  
**Distress:** Beyond Service Life  
**Category:** Deferred Maintenance / Appearance  
**Priority:** 3 - Necessary/Not Yet Critical (Years 2-5)  
**Correction:** Renew System  
**Qty:** 58,823.00  
**Unit of Measure:** S.F.  
**Estimate:** \$176,645.00  
**Assessor Name:** Somnath Das  
**Date Created:** 01/09/2017

**Notes:** Painted walls are maintained on an ad hoc basis with no regularly scheduled repainting. Many areas of the building are in need of re-painting. Humidity has caused some peeling. Vinyl wall coverings in classrooms is original and in poor condition with scuffs and peeling wall coverings. System renewal is recommended.

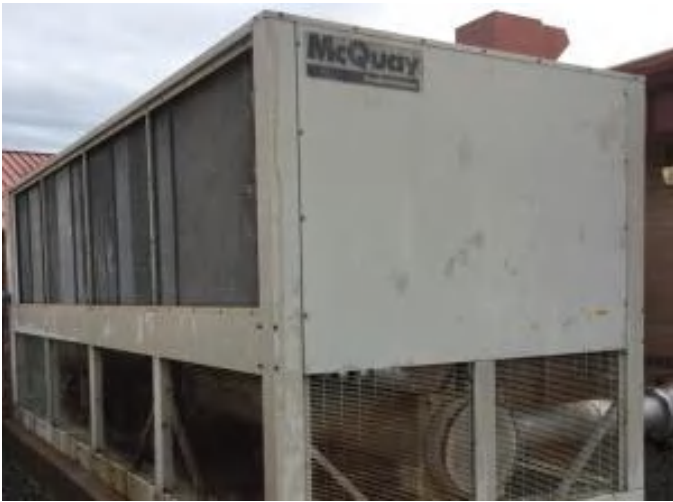
**System: D3030 - Cooling Generating Systems**

**Location:** Mechanical equipment yard  
**Distress:** Beyond Service Life  
**Category:** Deferred Maintenance  
**Priority:** 3 - Necessary/Not Yet Critical (Years 2-5)  
**Correction:** Renew System  
**Qty:** 58,823.00  
**Unit of Measure:** S.F.  
**Estimate:** \$333,879.00  
**Assessor Name:** Somnath Das  
**Date Created:** 01/11/2017

**Notes:** The air cooled chiller is nearing the end of its expected life and should be replaced to ensure cooling capacity for the school.

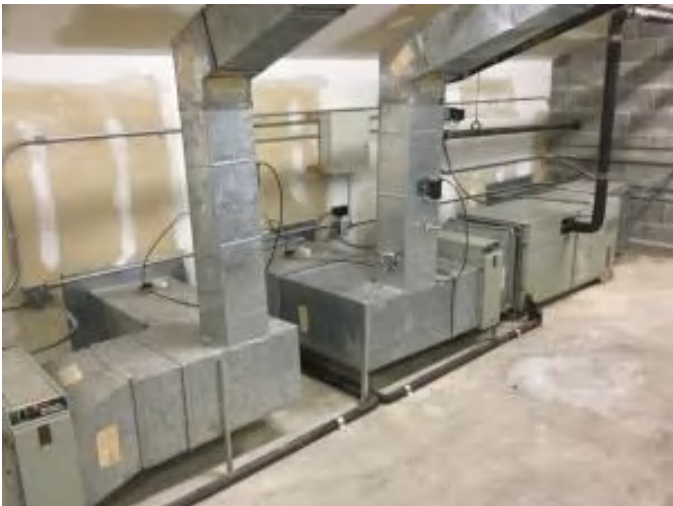
**System: D3040 - Distribution Systems**

**Location:** Throughout the building  
**Distress:** Inadequate  
**Category:** Deferred Maintenance / Energy  
**Priority:** 3 - Necessary/Not Yet Critical (Years 2-5)  
**Correction:** Renew System  
**Qty:** 58,823.00  
**Unit of Measure:** S.F.  
**Estimate:** \$389,526.00  
**Assessor Name:** Somnath Das  
**Date Created:** 01/11/2017

**Notes:** Internally insulated ductwork is used throughout the building. Air handlers are original and need balancing. System renewal is recommended.

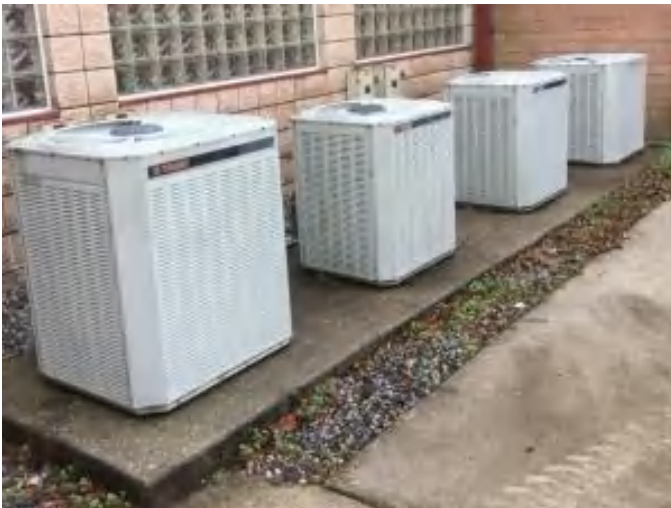
**System: D3050 - Terminal & Package Units**

**Location:** Front office  
**Distress:** Beyond Service Life  
**Category:** Deferred Maintenance / Energy  
**Priority:** 3 - Necessary/Not Yet Critical (Years 2-5)  
**Correction:** Renew System  
**Qty:** 58,823.00  
**Unit of Measure:** S.F.  
**Estimate:** \$191,528.00  
**Assessor Name:** Somnath Das  
**Date Created:** 01/09/2017

**Notes:** Split system heat pumps used at front office areas are original and well beyond their expected life. Closets / rooms converted to data rooms do not typically have adequate cooling/ventilation. System renewal with modern energy efficient equipment is recommended.

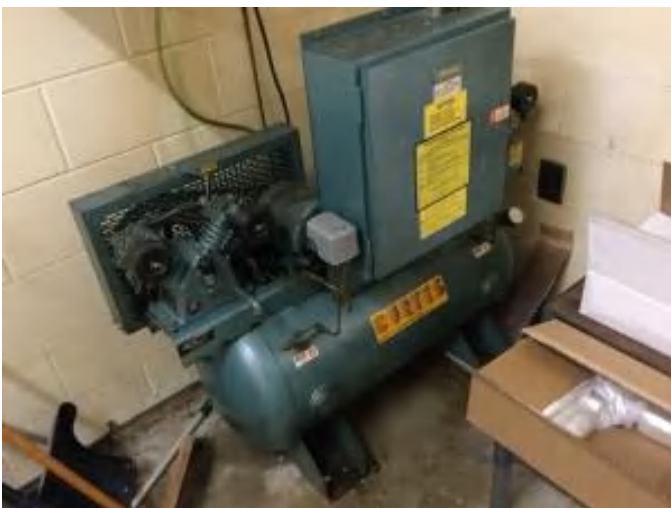
**System: D3060 - Controls & Instrumentation**

**Location:** Throughout the building  
**Distress:** Beyond Service Life  
**Category:** Deferred Maintenance / Energy  
**Priority:** 3 - Necessary/Not Yet Critical (Years 2-5)  
**Correction:** Renew System  
**Qty:** 58,823.00  
**Unit of Measure:** S.F.  
**Estimate:** \$123,587.00  
**Assessor Name:** Somnath Das  
**Date Created:** 01/09/2017

**Notes:** Building controls are typically original pneumatics. They are locally controlled. Installation of a modern digital system with remote monitoring and control capability for energy conservation is recommended.

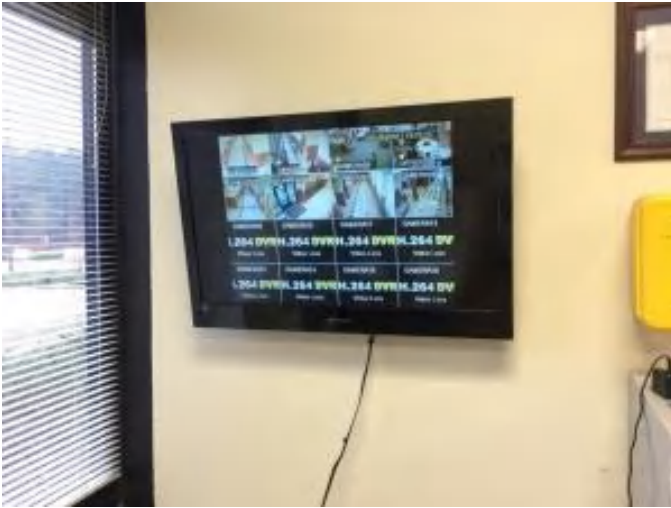
**System: D5030810 - Security & Detection Systems**

**Location:** Throughout the building  
**Distress:** Inadequate  
**Category:** Deferred Maintenance / Safety  
**Priority:** 3 - Necessary/Not Yet Critical (Years 2-5)  
**Correction:** Renew System  
**Qty:** 58,823.00  
**Unit of Measure:** S.F.  
**Estimate:** \$118,411.00  
**Assessor Name:** Somnath Das  
**Date Created:** 01/09/2017

**Notes:** The security system is mostly original and beyond its expected life. There are areas inside and outside the building that aren't monitored. Addition of magnetic locks at exterior doors is suggested. System renewal is recommended.

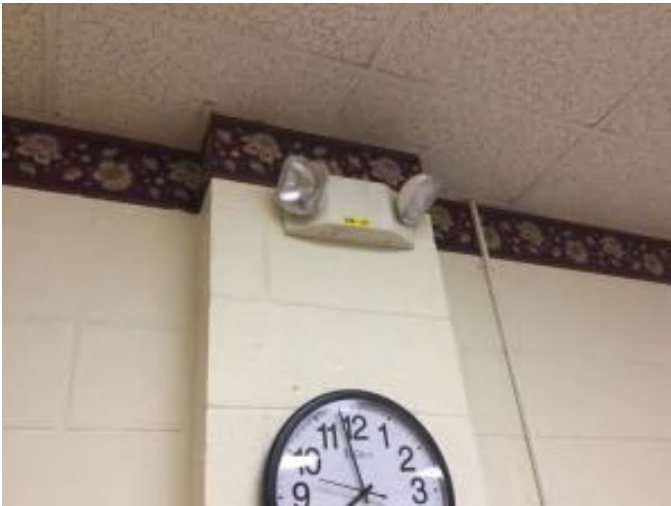
**System: D5090 - Other Electrical Systems**

**Location:** Throughout the building  
**Distress:** Beyond Service Life  
**Category:** Deferred Maintenance / Life Safety Code Compliance  
**Priority:** 3 - Necessary/Not Yet Critical (Years 2-5)  
**Correction:** Renew System  
**Qty:** 58,823.00  
**Unit of Measure:** S.F.  
**Estimate:** \$7,765.00  
**Assessor Name:** Somnath Das  
**Date Created:** 01/11/2017

**Notes:** Emergency lighting systems are believed to be original and are beyond their expected service life. As this is a Life Safety concern, system renewal is recommended.

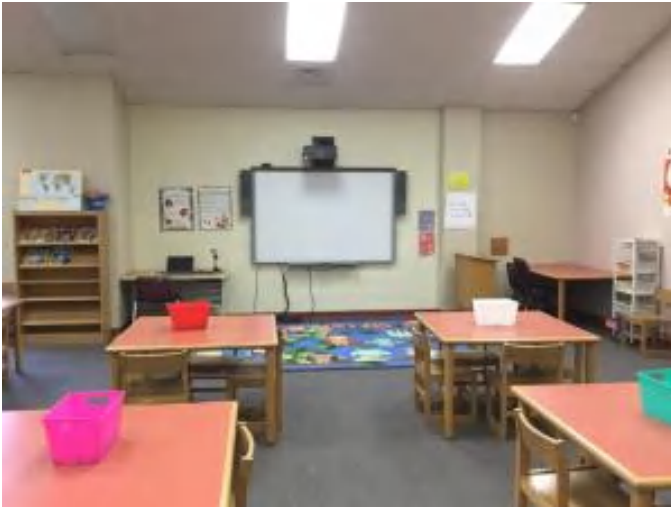
**System: E1020 - Institutional Equipment**

**Location:** Throughout the school  
**Distress:** Beyond Service Life  
**Category:** Deferred Maintenance  
**Priority:** 3 - Necessary/Not Yet Critical (Years 2-5)  
**Correction:** Renew System  
**Qty:** 58,823.00  
**Unit of Measure:** S.F.  
**Estimate:** \$19,412.00  
**Assessor Name:** Somnath Das  
**Date Created:** 01/11/2017

**Notes:** Institutional equipment as a system is generally beyond its expected life. In particular, the number of Smartboards is inadequate. System renewal is recommended.

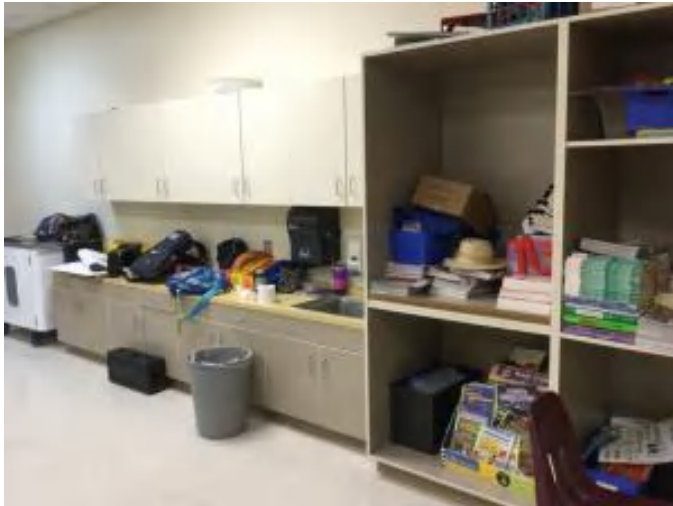
**System: E2010 - Fixed Furnishings**

**Location:** Throughout the building.  
**Distress:** Beyond Service Life  
**Category:** Deferred Maintenance  
**Priority:** 3 - Necessary/Not Yet Critical (Years 2-5)  
**Correction:** Renew System  
**Qty:** 58,823.00  
**Unit of Measure:** S.F.  
**Estimate:** \$370,114.00  
**Assessor Name:** Somnath Das  
**Date Created:** 01/09/2017

**Notes:** Fixed furnishings including classroom cabinetry and window treatments are beyond their expected useful life and are showing some signs of wear and tear. Window treatments are missing at many spaces, creating glare. System renewal is recommended.

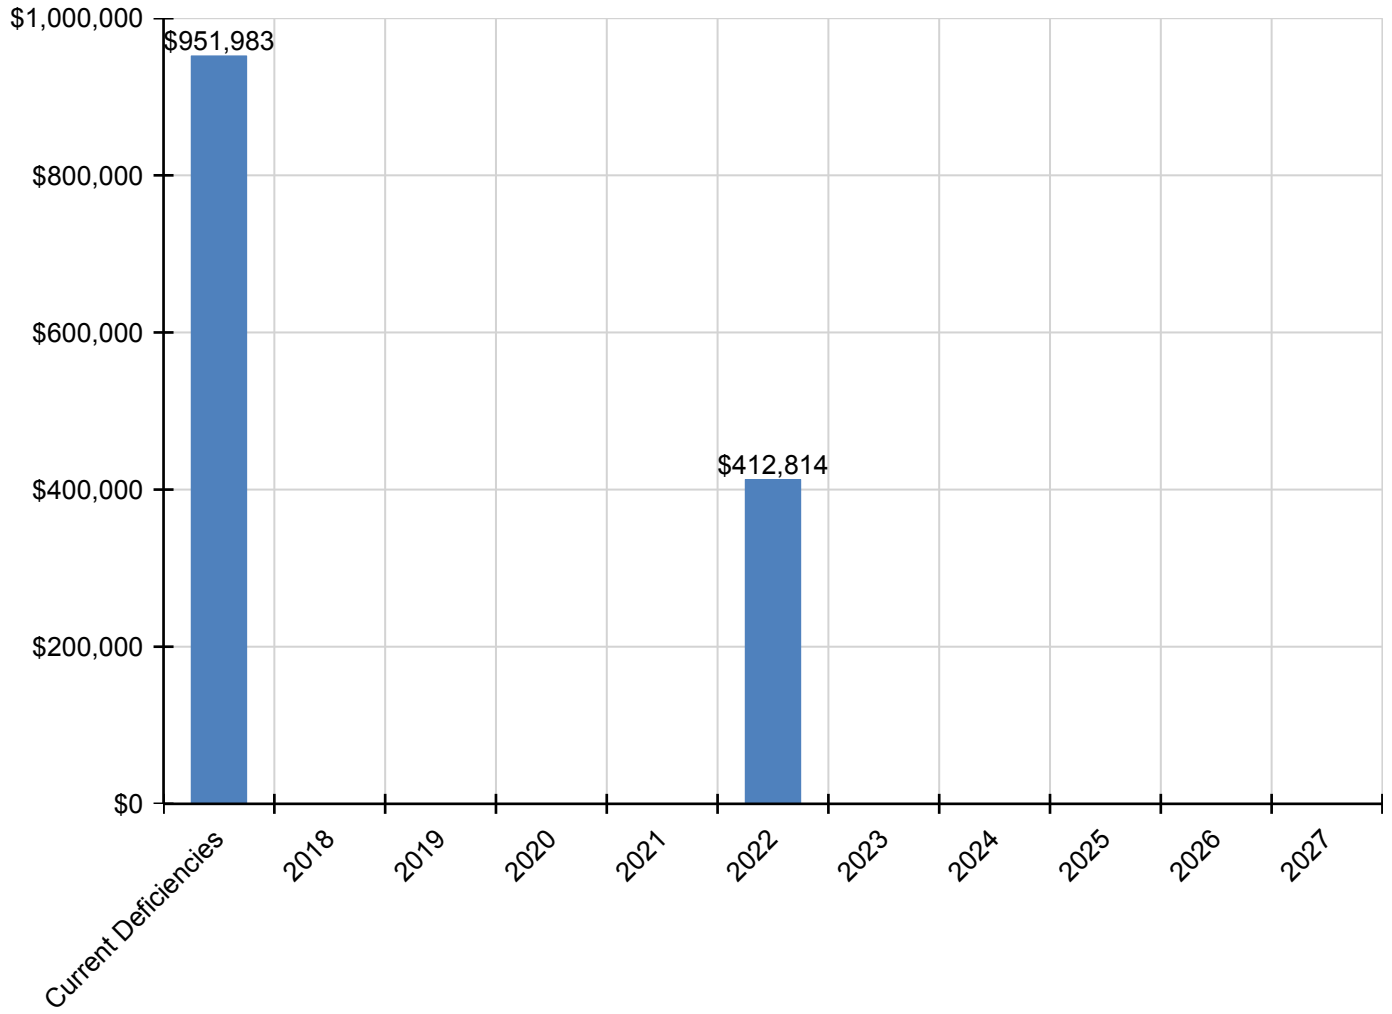
## Forecasted Capital Renewal Requirement

The following chart shows the current building deficiencies and forecasting capital renewal or sustainment requirements over the next ten years.

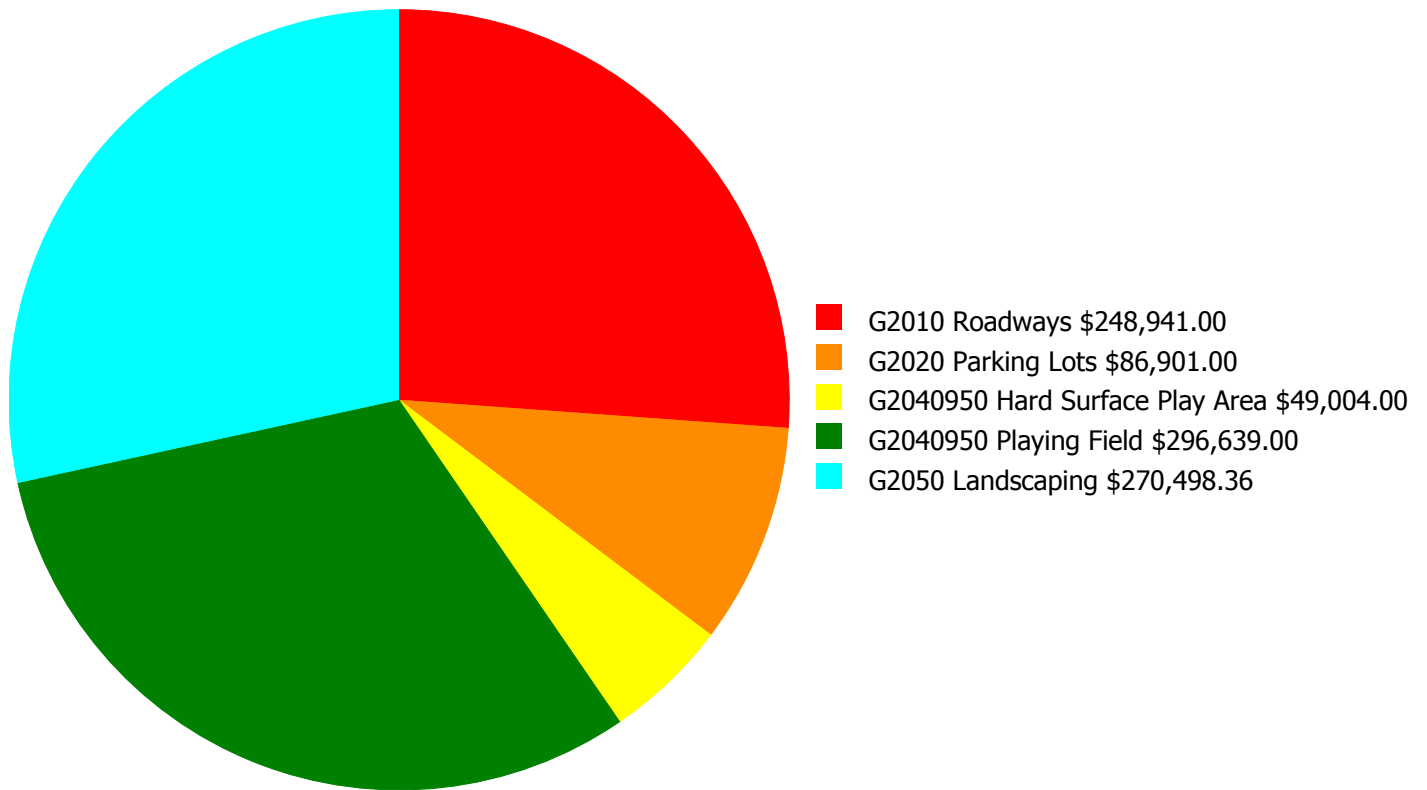
## Deficiency Summary by System

Current deficiencies included assemblies that have reached or exceeded their design life or components of the assemblies that are in need of repair. Assemblies that have reached their design life are identified as current deficiencies and assigned the distress 'Beyond Useful Life'. The following chart lists all current deficiencies associated with this facility.

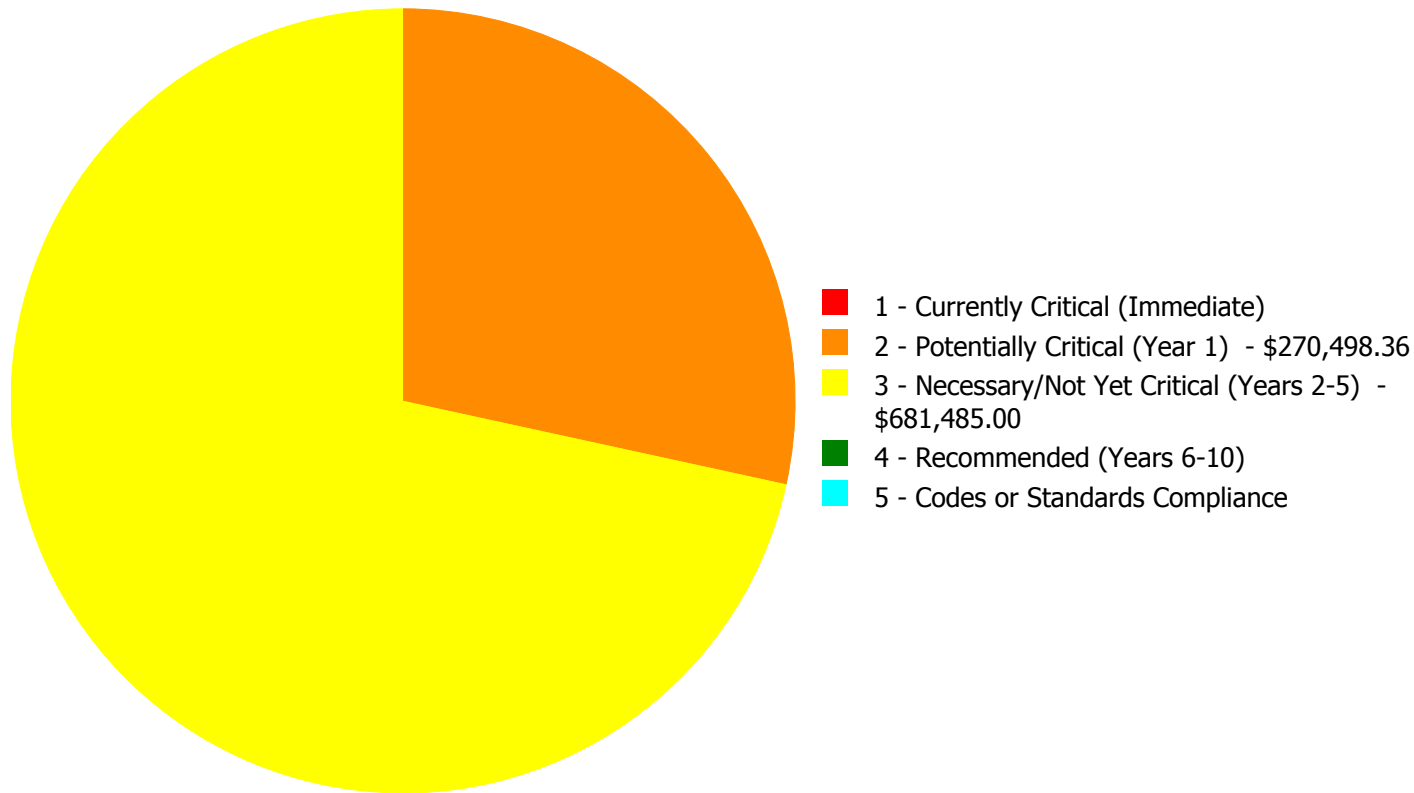
## Deficiency Summary by Priority

The following chart shows the total repair costs broken down by priority. Assessors assigned deficiencies within eCOMET to one of the following priority categories:

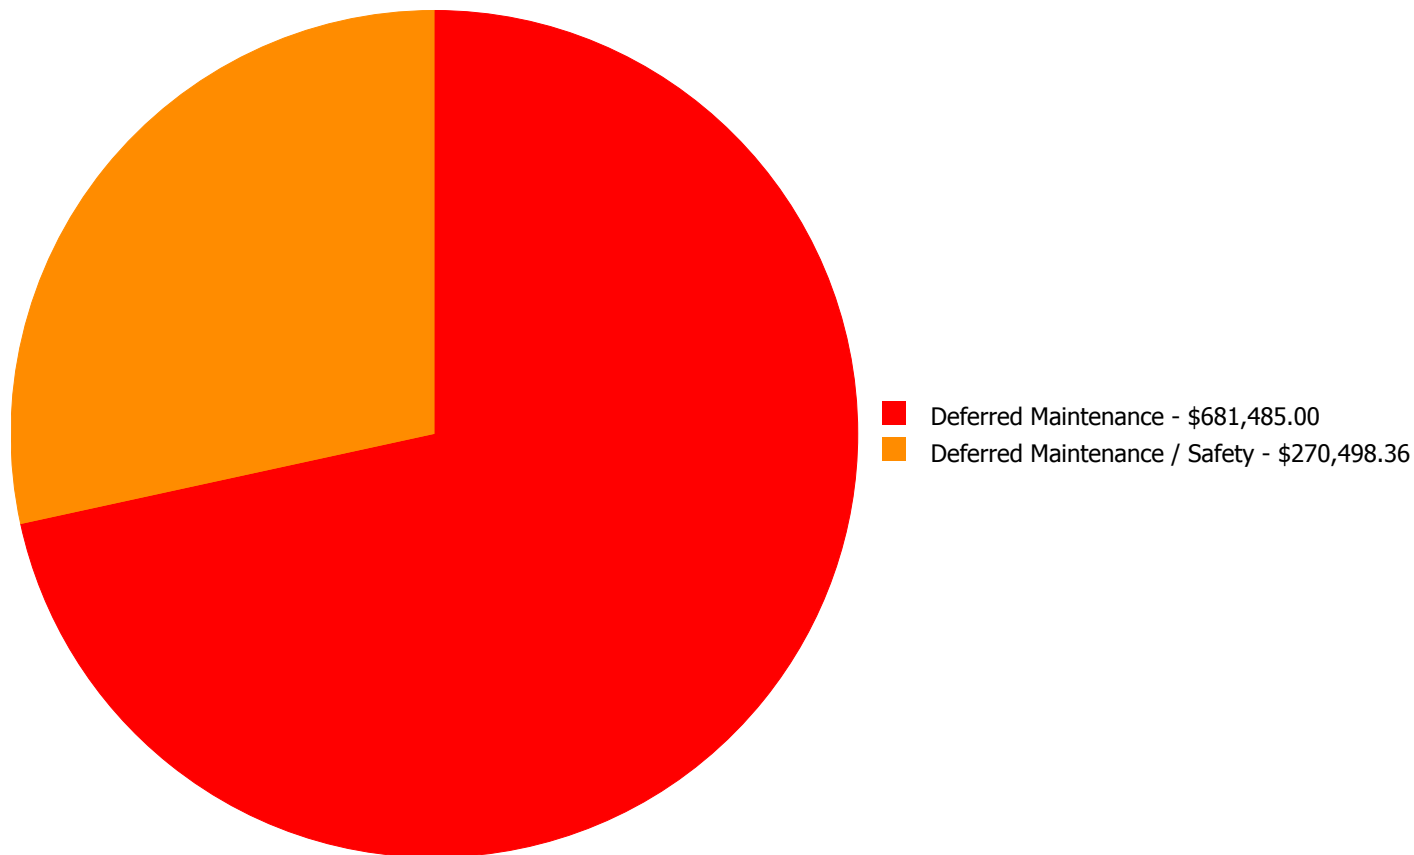
## Deficiency Summary by Category

The following chart shows the total repair costs broken down by deficiency categories. Assessors assigned deficiencies to one of the following categories:

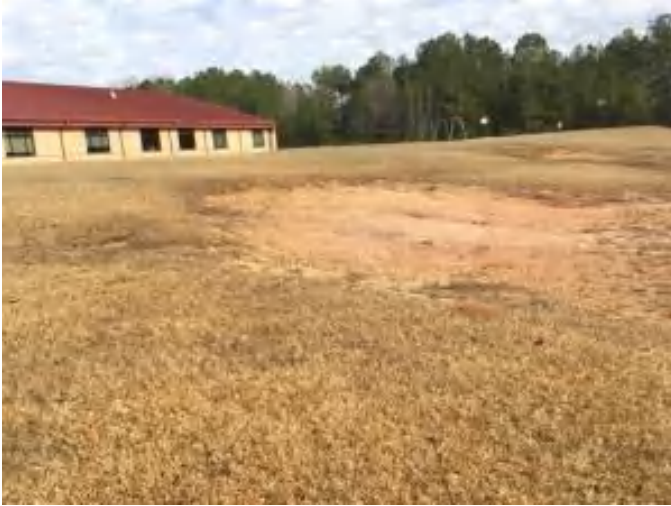
#### **System: G2050 - Landscaping**

**Location:** Site, south side  
**Distress:** Failing  
**Category:** Deferred Maintenance / Safety  
**Priority:** 2 - Potentially Critical (Year 1)  
**Correction:** Erosion control; incl. soil preparation, topsoil and sodding  
**Qty:** 10,000.00  
**Unit of Measure:** S.F.  
**Estimate:** \$270,498.36  
**Assessor Name:** Terence Davis  
**Date Created:** 01/12/2017

**Notes:** The steep slopes above the playing field are eroded, creating a safety concern for students and maintenance personnel. Repairs are recommended.

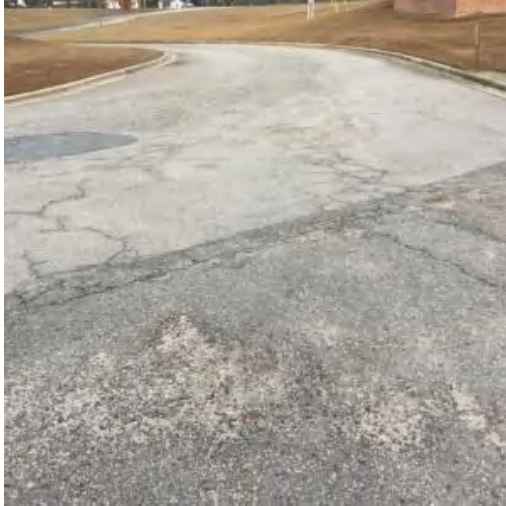
**System: G2010 - Roadways**

**Location:** Site  
**Distress:** Beyond Service Life  
**Category:** Deferred Maintenance  
**Priority:** 3 - Necessary/Not Yet Critical (Years 2-5)  
**Correction:** Renew System  
**Qty:** 59,399.00  
**Unit of Measure:** S.F.  
**Estimate:** \$248,941.00  
**Assessor Name:** Terence Davis  
**Date Created:** 12/19/2016

**Notes:** The asphalt roadway is beyond its expected life. It is aged with a worn surface and cracks. Provide Fire lane markings per Local Code requirements..

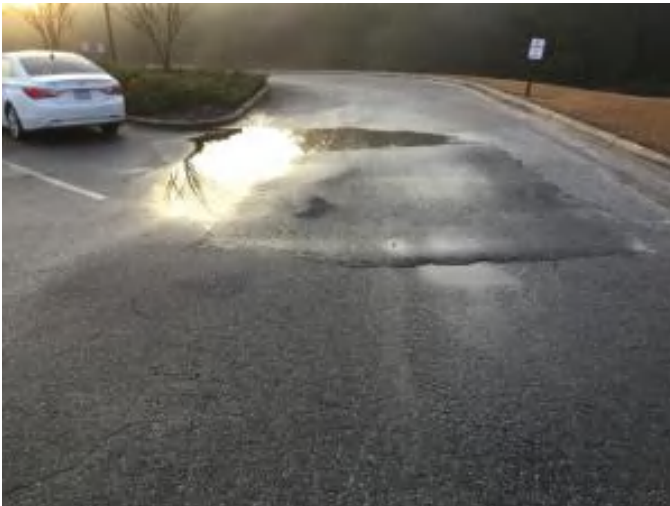
**System: G2020 - Parking Lots**

**Location:** Site  
**Distress:** Beyond Service Life  
**Category:** Deferred Maintenance  
**Priority:** 3 - Necessary/Not Yet Critical (Years 2-5)  
**Correction:** Renew System  
**Qty:** 59,399.00  
**Unit of Measure:** S.F.  
**Estimate:** \$86,901.00  
**Assessor Name:** Terence Davis  
**Date Created:** 12/19/2016

**Notes:** The parking lot is aged, has cracks, and a rough worn surface.with exposed aggregate. Patching as altered drainage pattern, creating ponding. Replace / resurface paving. Re-stripe parking spaces and provide pavement markings. ADA signs need to be adjusted per minimum ADA standards.

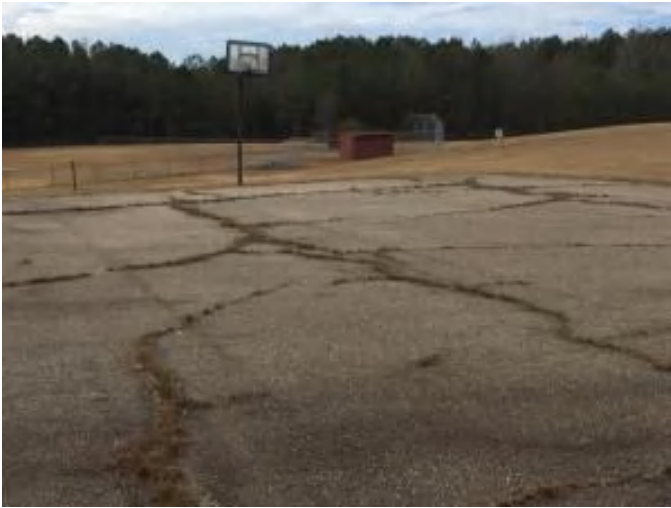
**System: G2040950 - Hard Surface Play Area**

**Location:** Site  
**Distress:** Beyond Service Life  
**Category:** Deferred Maintenance  
**Priority:** 3 - Necessary/Not Yet Critical (Years 2-5)  
**Correction:** Renew System  
**Qty:** 59,399.00  
**Unit of Measure:** S.F.  
**Estimate:** \$49,004.00  
**Assessor Name:** Terence Davis  
**Date Created:** 12/19/2016

**Notes:** The asphalt surfaced basketball court is in poor condition, creating a safety hazard, and/or an unusable asset. Replacement is recommended. In addition, the basketball backstops are in weathered condition and should be upgraded.

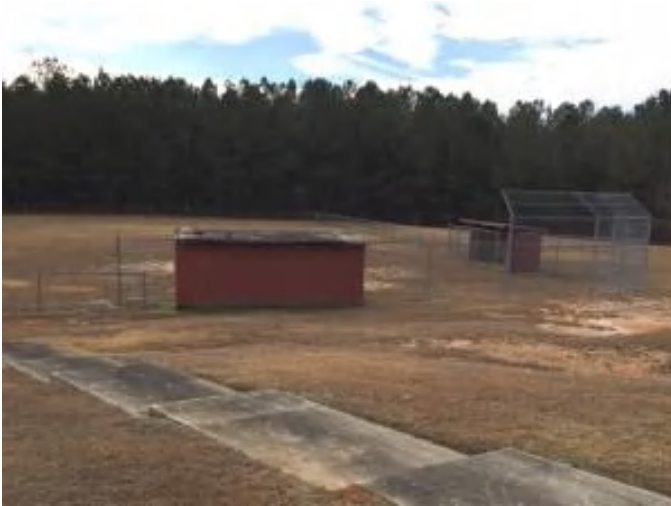
**System: G2040950 - Playing Field**

**Location:** Site  
**Distress:** Beyond Service Life  
**Category:** Deferred Maintenance  
**Priority:** 3 - Necessary/Not Yet Critical (Years 2-5)  
**Correction:** Renew System  
**Qty:** 59,399.00  
**Unit of Measure:** S.F.  
**Estimate:** \$296,639.00  
**Assessor Name:** Terence Davis  
**Date Created:** 12/19/2016

**Notes:** The playing field is beyond its expected life. System renewal is recommended.

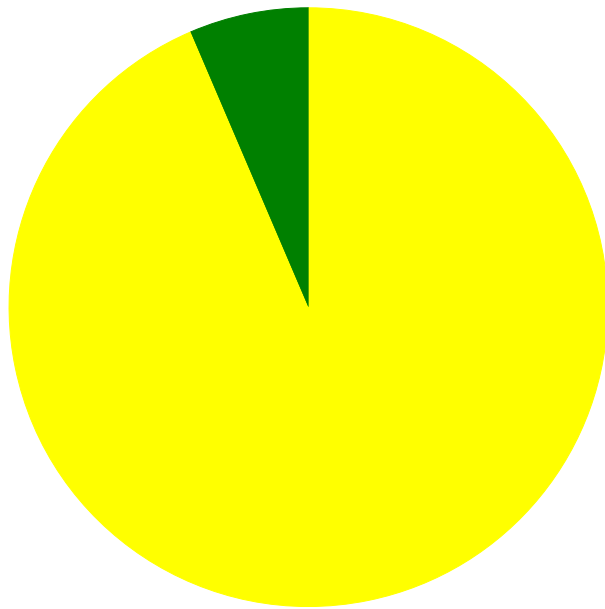
**Deficiencies By Priority**

- 1 - Currently Critical (Immediate)
- 2 - Potentially Critical (Year 1)
- 3 - Necessary/Not Yet Critical (Years 2-5) - \$5,092,834.44
- 4 - Recommended (Years 6-10) - \$350,310.00
- 5 - Codes or Standards Compliance

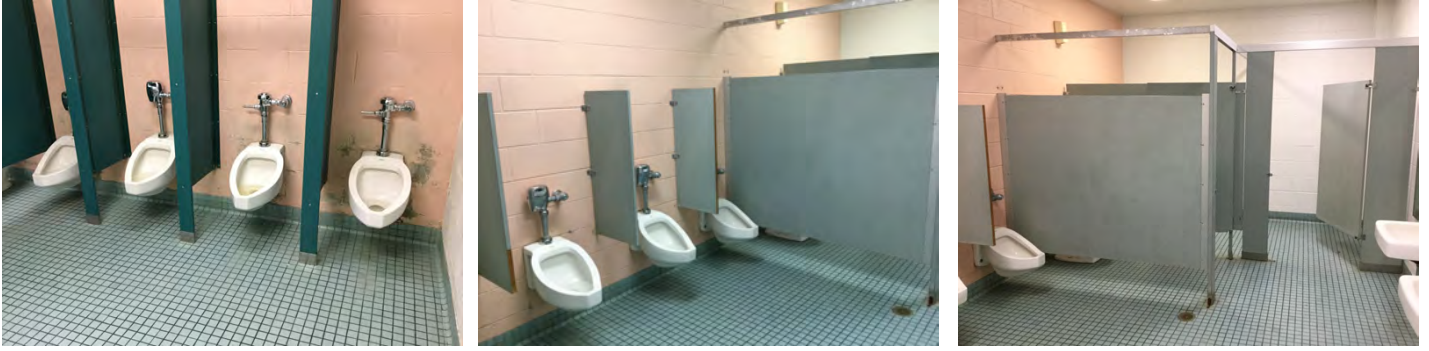
**System:** C1030 - Fittings

**Note:** The toilet partition and the signages throughout the school needs to be replaced.

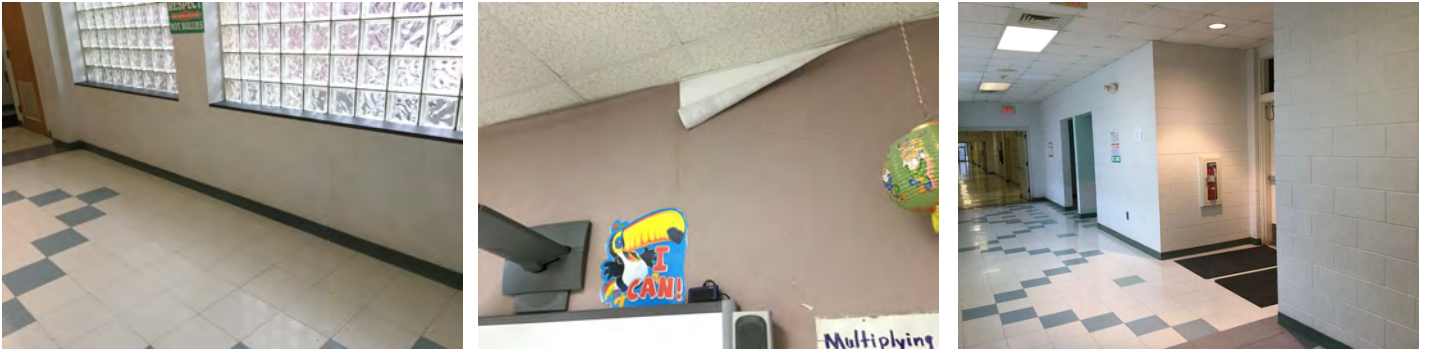
**System:** C3010 - Wall Finishes

**Note:** The paint is beyond its service life and should be replaced.
