# Anson Middle

## Campus Assessment Report

March 7, 2017

## Campus Assessment Report - 1966 Building, Cafe/Gym

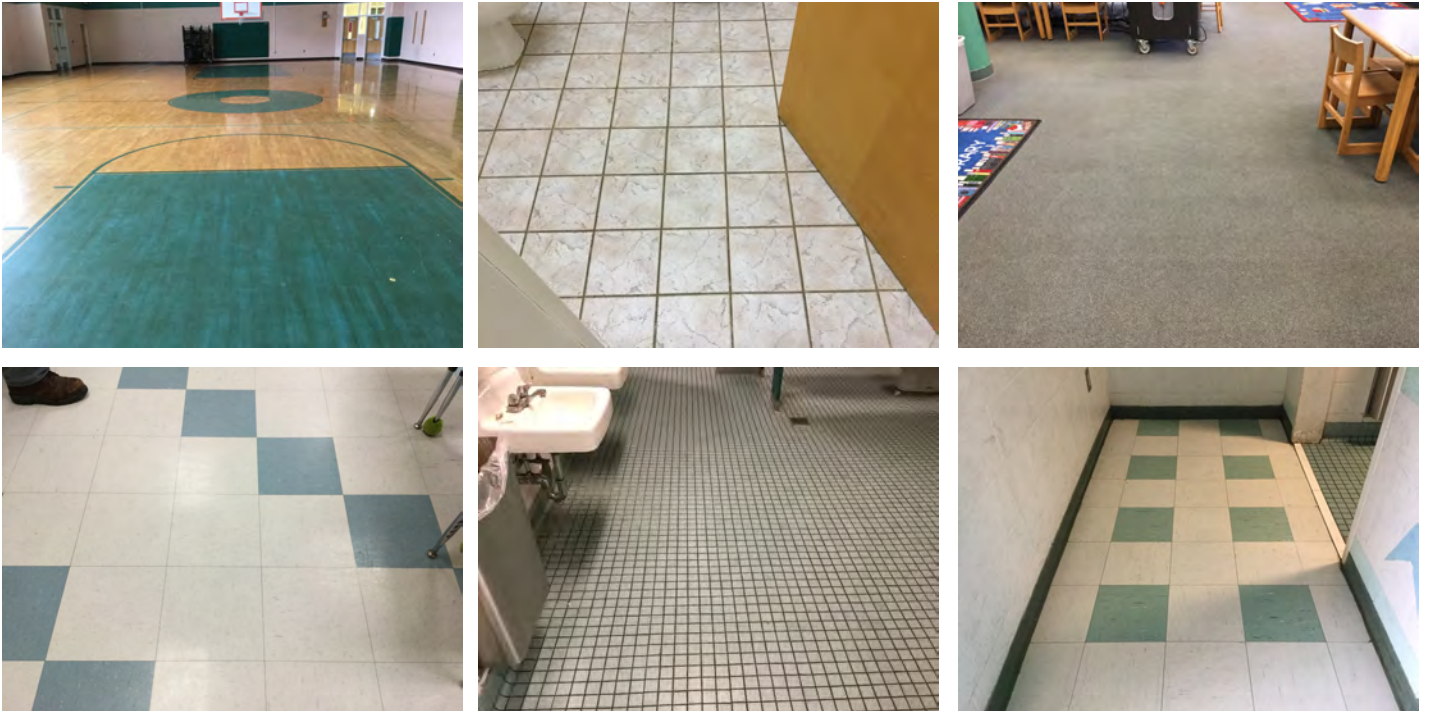
**System:** C3020 - Floor Finishes

**Note:** The carpet and portion of the VCT needs to be replaced.

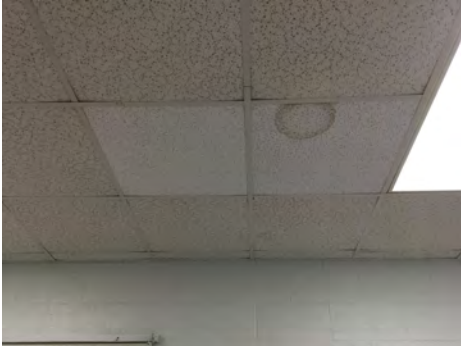
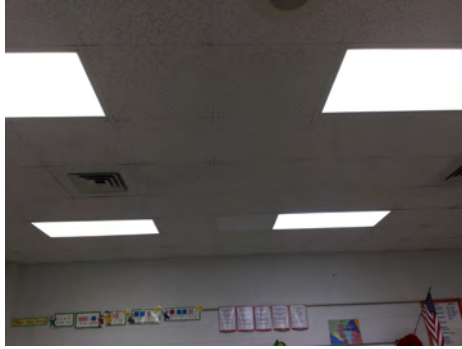
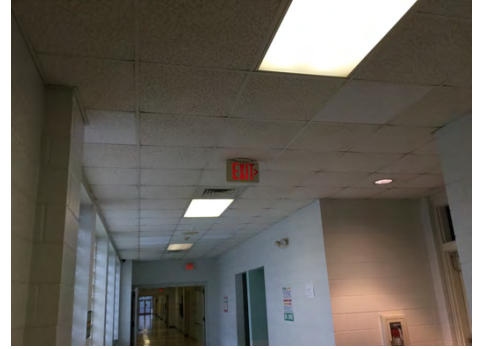
### System: C3030 - Ceiling Finishes

**Note:** The acoustical ceiling tiles are beyond their service life and should be replaced.

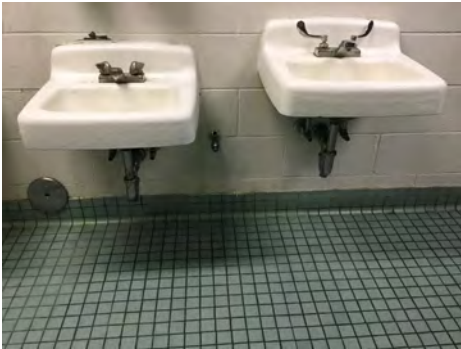
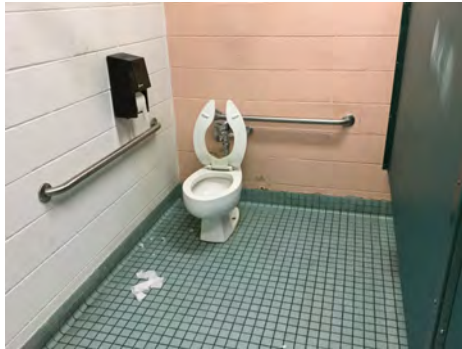
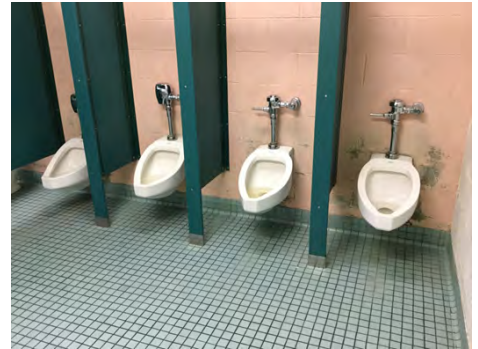
### System: D2010 - Plumbing Fixtures

**Note:** The plumbing fixtures are beyond their service life and should be replaced.

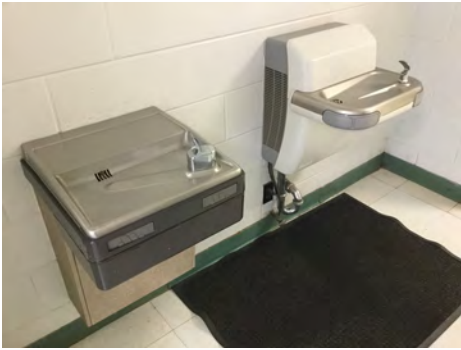
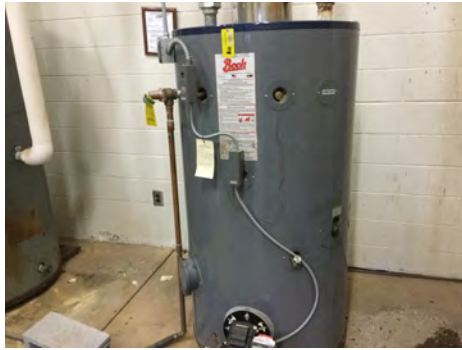
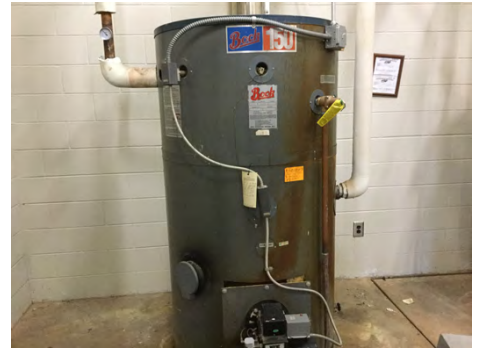
### System: D2020 - Domestic Water Distribution

**Note:** The domestic water distribution system is beyond its service life and should be replaced.

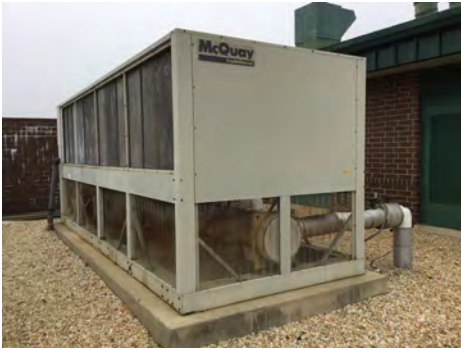
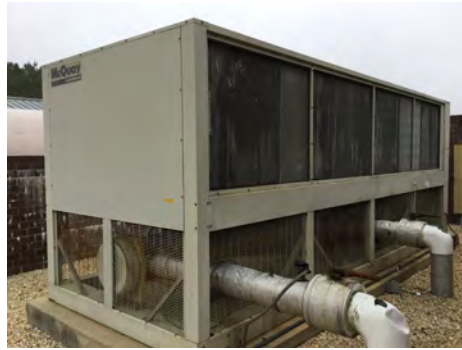
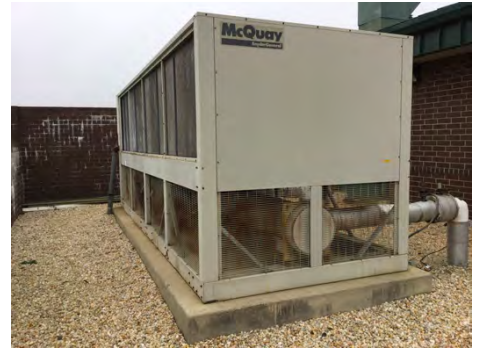
**System:** D3030 - Cooling Generating Systems

**Note:** The cooling system is beyond its service life and should be replaced.

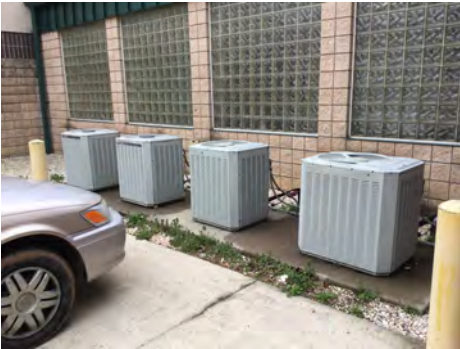
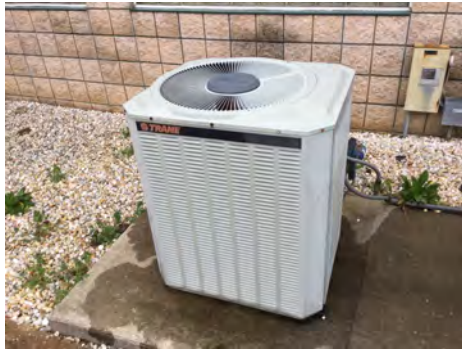
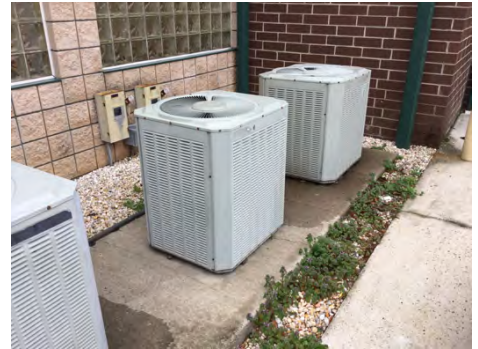
**System:** D3050 - Terminal & Package Units

**Note:** The terminal and package units are beyond their service life and should be replaced.

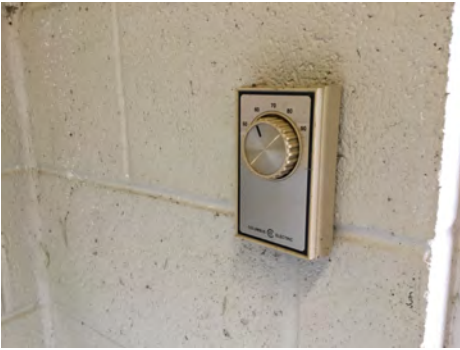
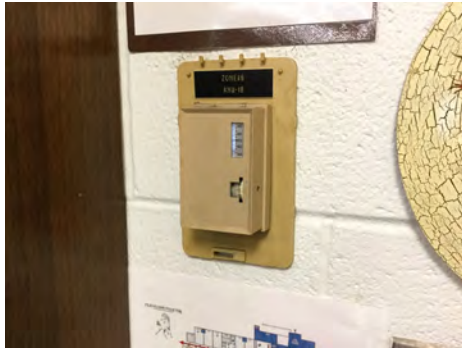
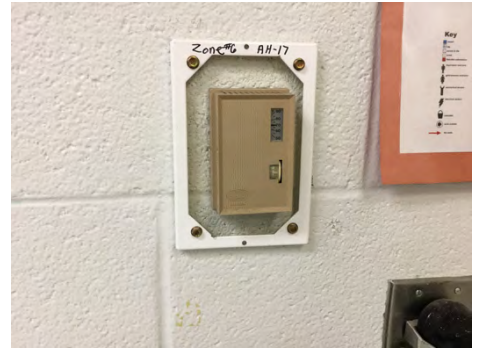
**System:** D3060 - Controls & Instrumentation

**Note:** The controls and instrumentation are beyond its service life and should be replaced.

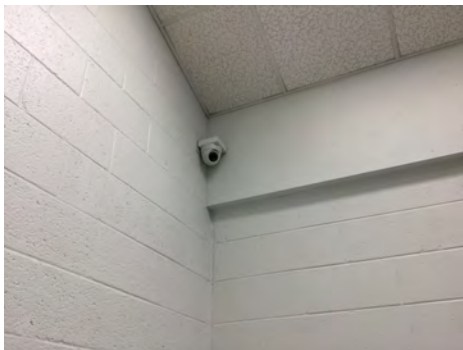
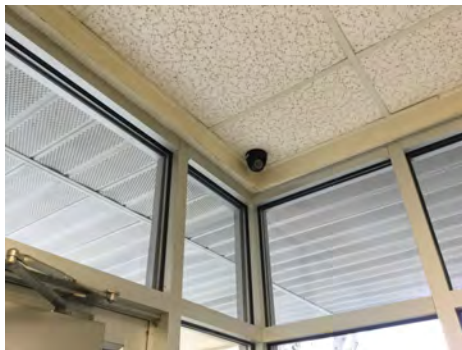
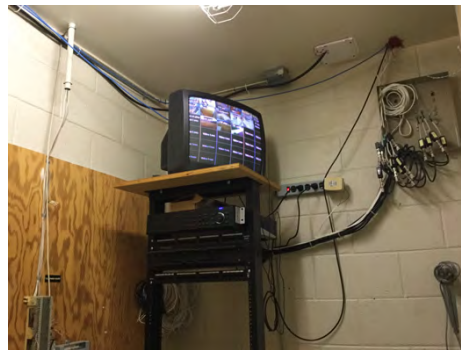
### System: D5030810 - Security & Detection Systems

**Note:** The security and detection system is beyond its service life and should be replaced.

**Notes:** The security and detection system is beyond its service life and should be replaced.

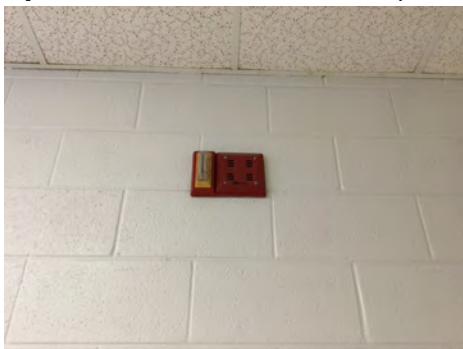
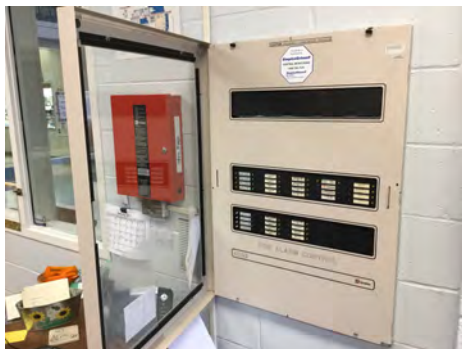
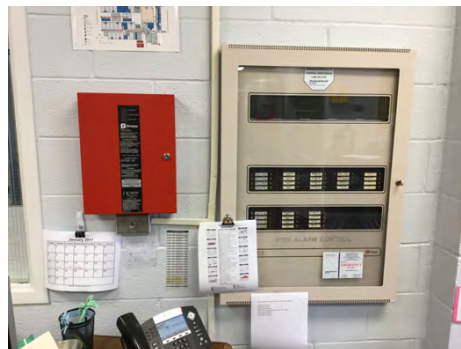
### System: D5030910 - Fire Alarm Systems

**Note:** The fire alarm system is beyond its service life and should be replaced.

**Notes:** The fire alarm system is beyond its service life and should be replaced.

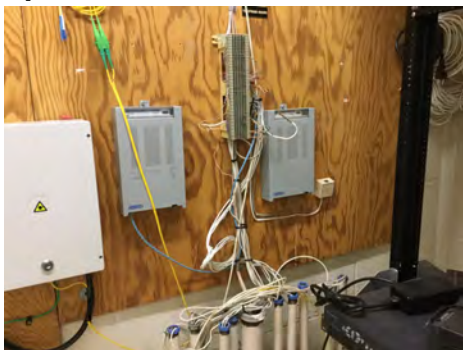
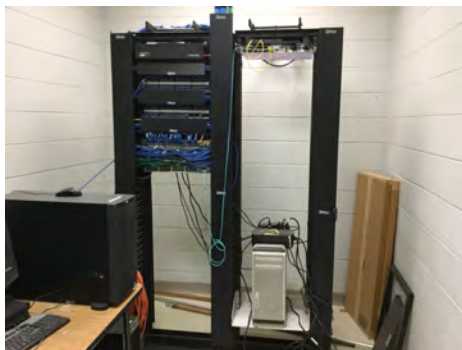
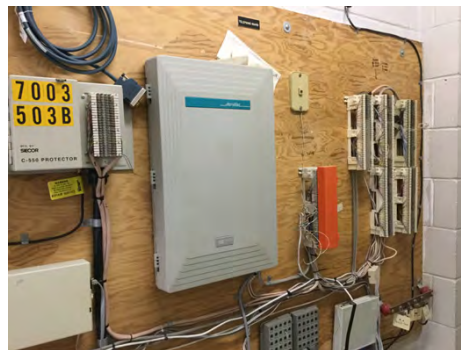
### System: D5030920 - Data Communication

**Note:** The data communication is beyond its service life and should be replaced.

**Notes:** The data communication is beyond its service life and should be replaced.

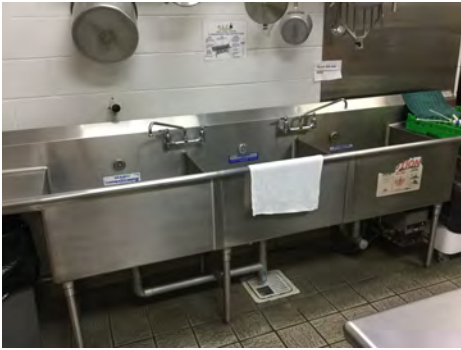
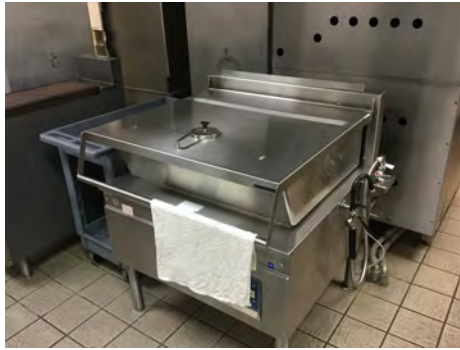
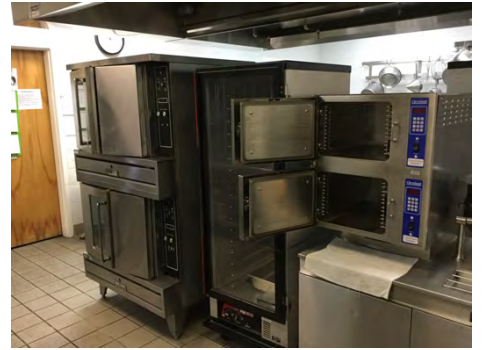
**System:** E1090 - Other Equipment

**Note:** The kitchen equipment is beyond its service life and should be replaced.

**Notes:** The kitchen equipment is beyond its service life and should be replaced.

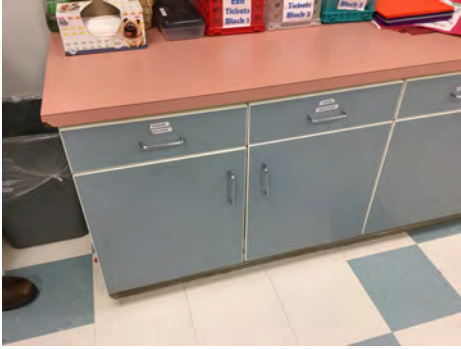
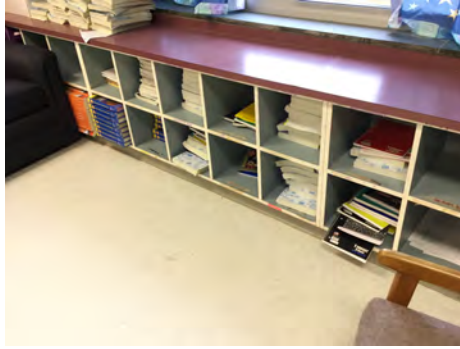
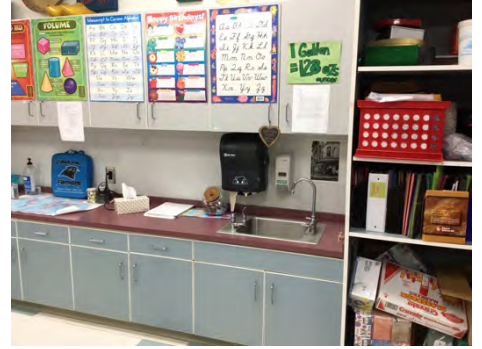
**System:** E2010 - Fixed Furnishings

**Note:** The fixed furnishings are beyond their service life and should be replaced.

**Notes:** The fixed furnishings are beyond their service life and should be replaced.

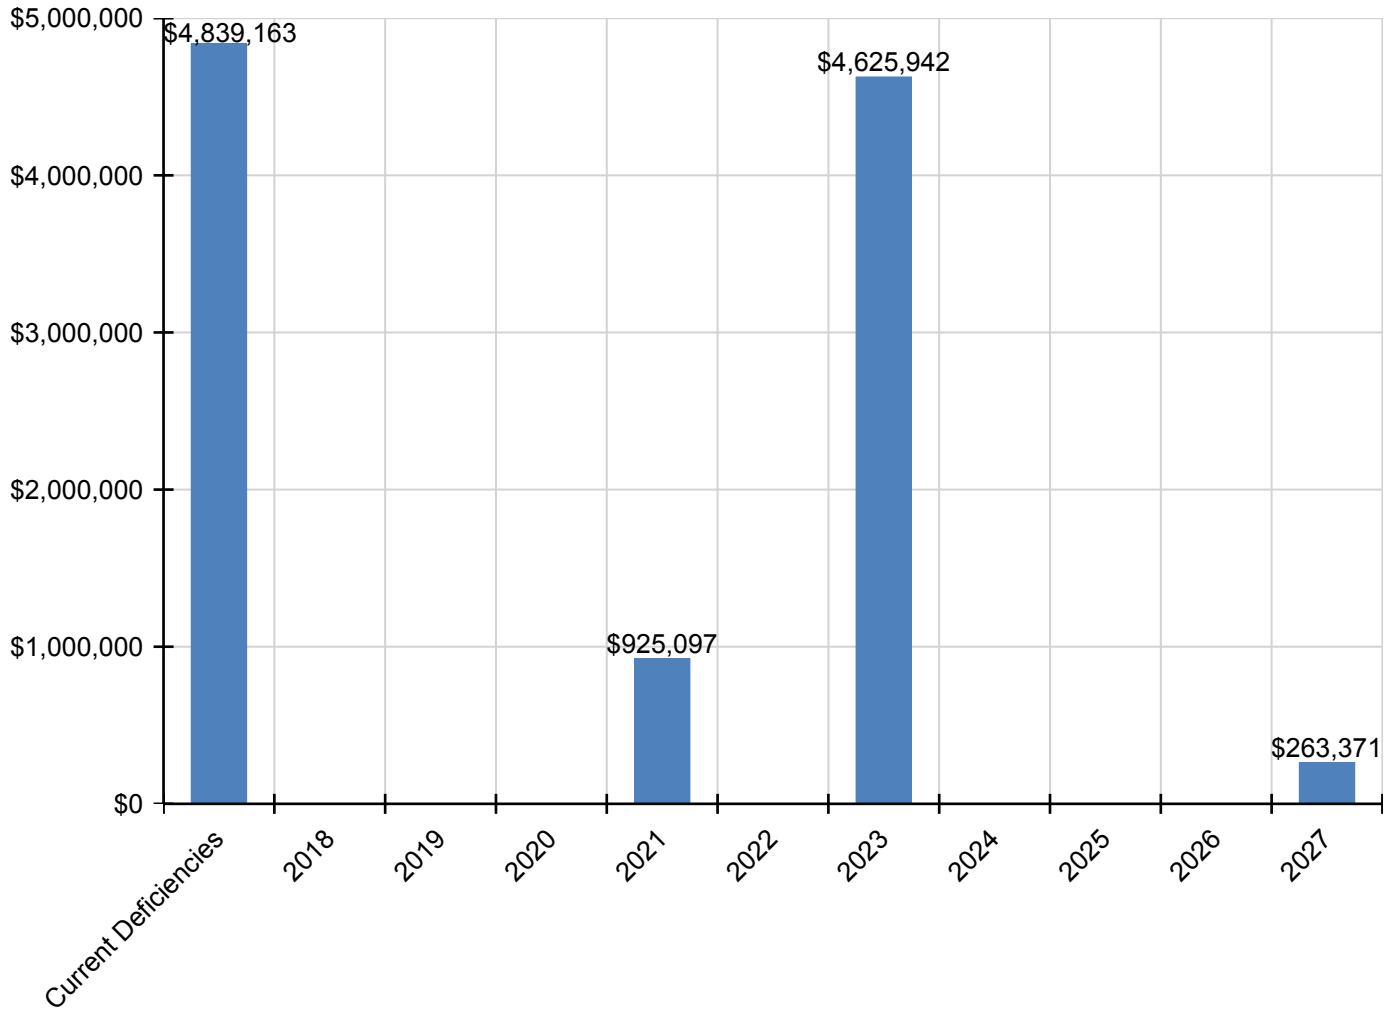
## Forecasted Capital Renewal Requirement

The following chart shows the current building deficiencies and forecasting capital renewal or sustainment requirements over the next ten years.

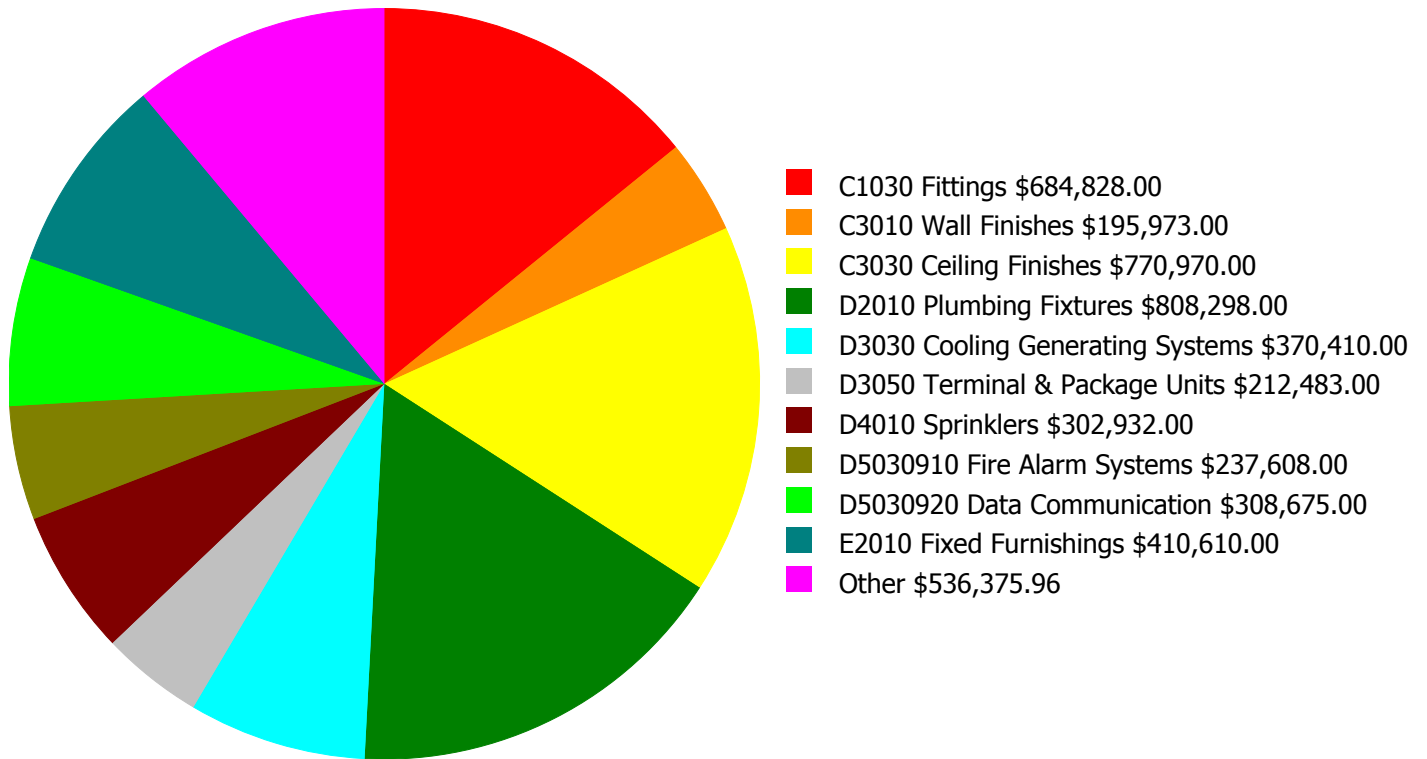
## Deficiency Summary by System

Current deficiencies included assemblies that have reached or exceeded their design life or components of the assemblies that are in need of repair. Assemblies that have reached their design life are identified as current deficiencies and assigned the distress 'Beyond Useful Life'. The following chart lists all current deficiencies associated with this facility.

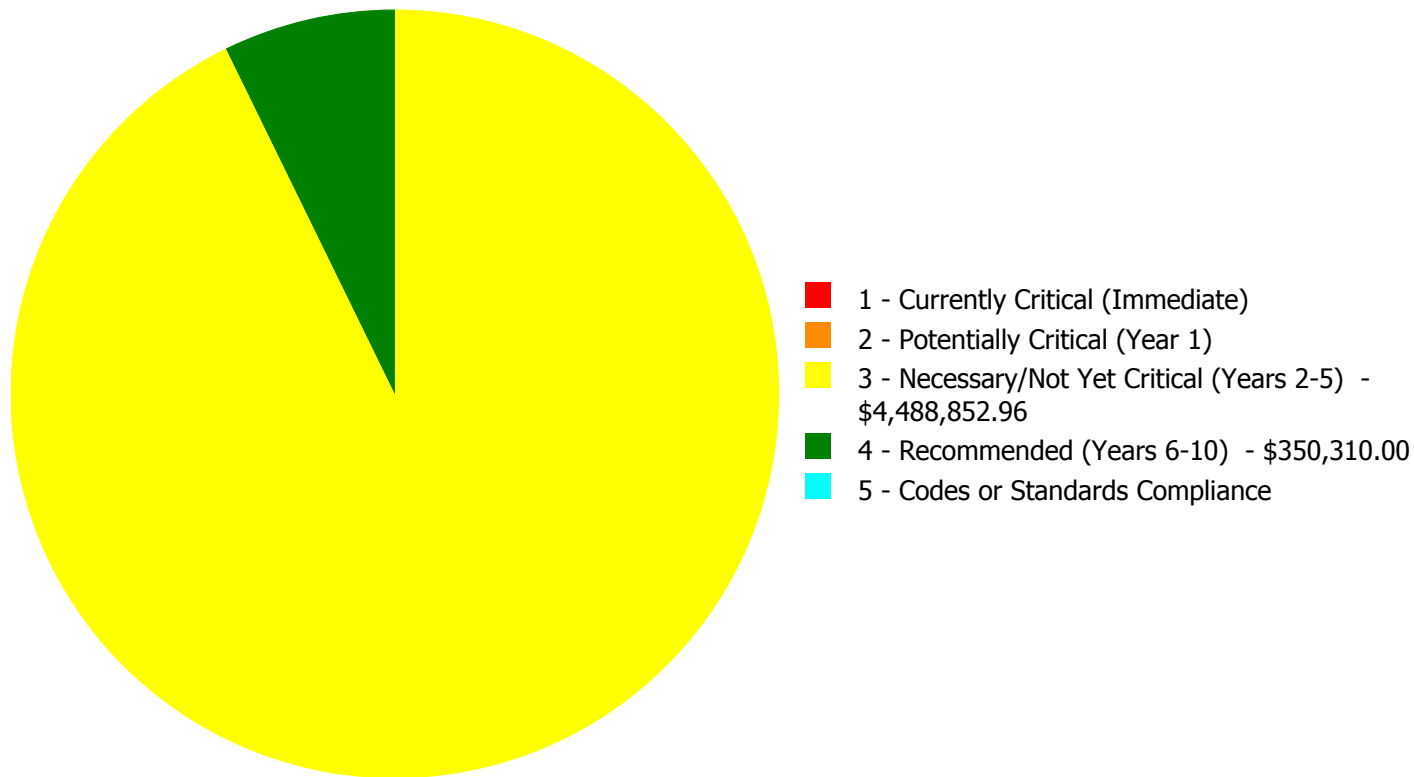
### Deficiency Summary by Priority

The following chart shows the total repair costs broken down by priority. Assessors assigned deficiencies within eCOMET to one of the following priority categories:

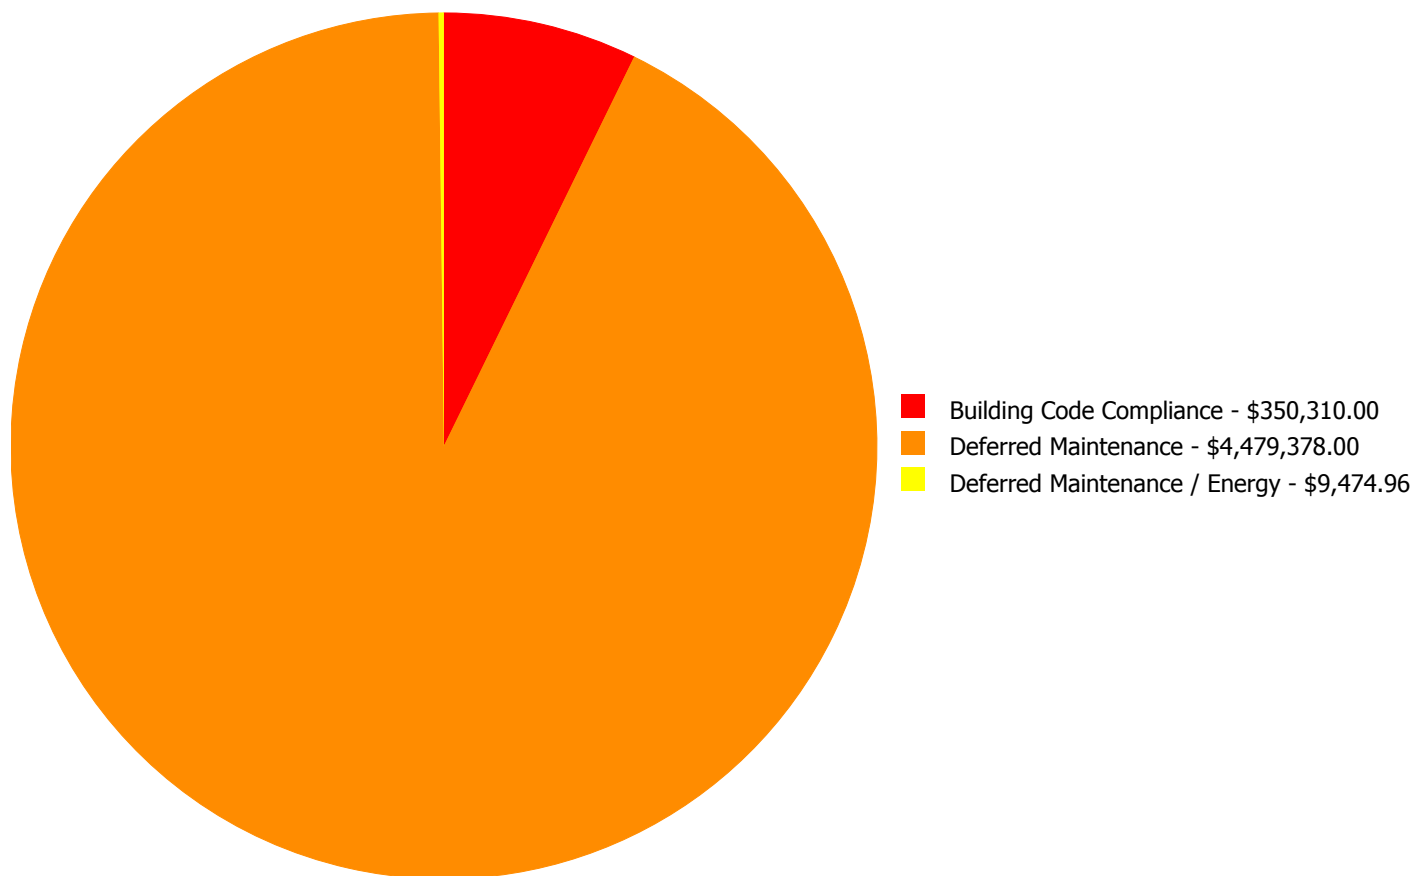
### Deficiency Summary by Category

The following chart shows the total repair costs broken down by deficiency categories. Assessors assigned deficiencies to one of the following categories:

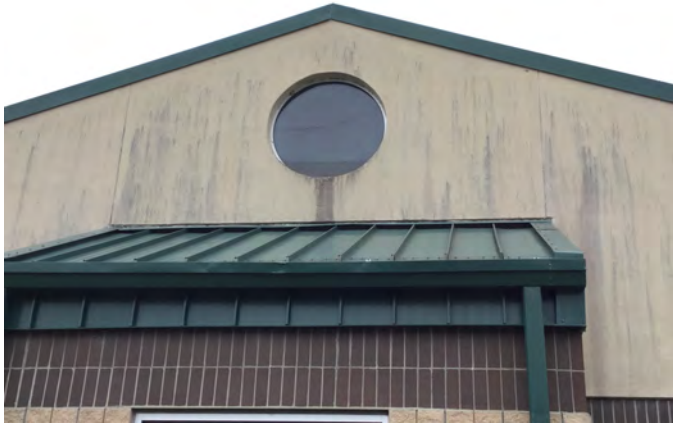
#### System: B2020 - Exterior Windows

**Location:** Exterior Walls  
**Distress:** Failing  
**Category:** Deferred Maintenance / Energy  
**Priority:** 3 - Necessary/Not Yet Critical (Years 2-5)  
**Correction:** Repair 3' x 4' aluminum window - 1st floor  
**Qty:** 20.00  
**Unit of Measure:** Ea.  
**Estimate:** \$9,474.96  
**Assessor Name:** Eduardo Lopez  
**Date Created:** 01/18/2017

**Notes:** The exterior windows need to be resealed as the sealing is in poor condition.

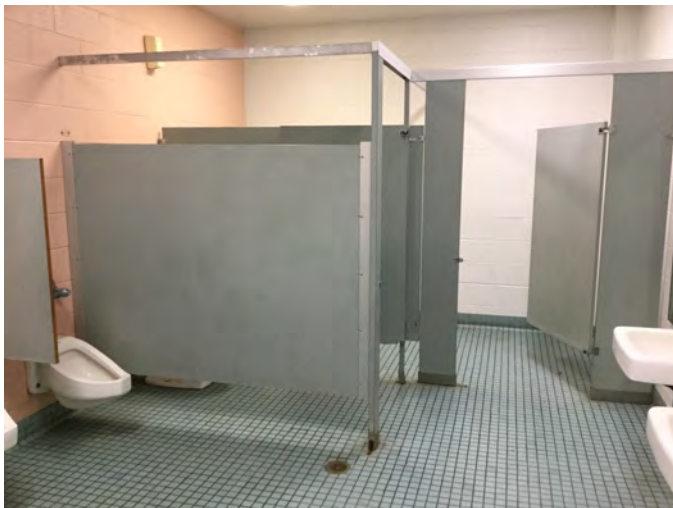
#### System: C1030 - Fittings

**Location:** Throughout Building  
**Distress:** Beyond Service Life  
**Category:** Deferred Maintenance  
**Priority:** 3 - Necessary/Not Yet Critical (Years 2-5)  
**Correction:** Renew System  
**Qty:** 65,259.00  
**Unit of Measure:** S.F.  
**Estimate:** \$684,828.00  
**Assessor Name:** Eduardo Lopez  
**Date Created:** 01/16/2017

**Notes:** The toilet partition and the signages throughout the school needs to be replaced.

**Note:** The toilet partition and the signages throughout the school needs to be replaced.

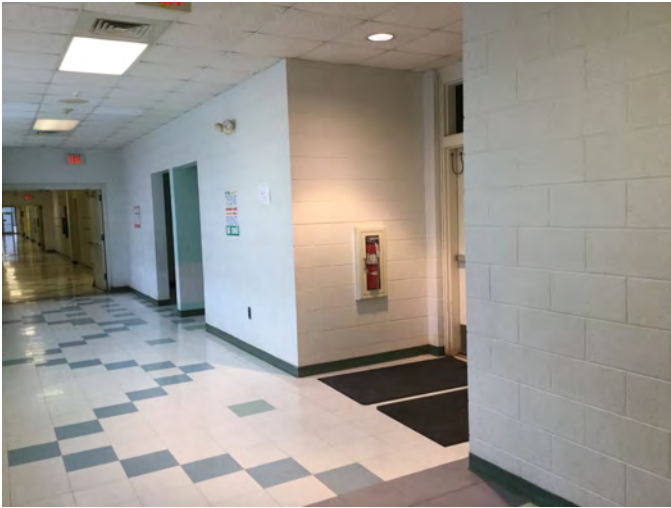
**System: C3010 - Wall Finishes**

**Location:** Throughout Building  
**Distress:** Beyond Service Life  
**Category:** Deferred Maintenance  
**Priority:** 3 - Necessary/Not Yet Critical (Years 2-5)  
**Correction:** Renew System  
**Qty:** 65,259.00  
**Unit of Measure:** S.F.  
**Estimate:** \$195,973.00  
**Assessor Name:** Eduardo Lopez  
**Date Created:** 01/16/2017

**Notes:** The paint is beyond its service life and should be replaced.

**Note:** The paint is beyond its service life and should be replaced.

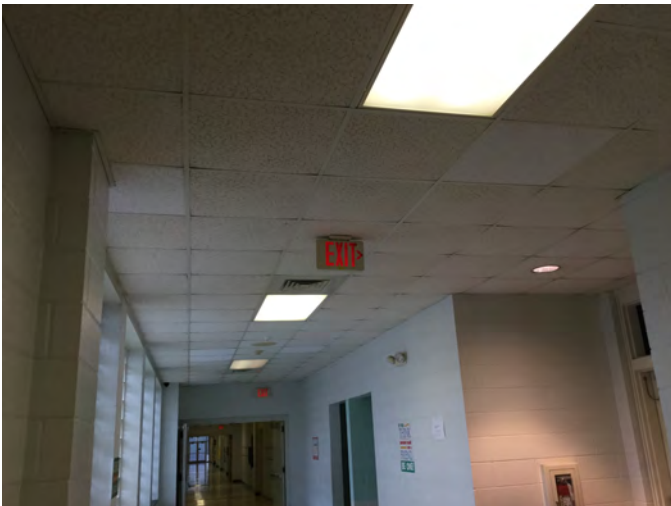
**System: C3030 - Ceiling Finishes**

**Location:** Throughout Building  
**Distress:** Beyond Service Life  
**Category:** Deferred Maintenance  
**Priority:** 3 - Necessary/Not Yet Critical (Years 2-5)  
**Correction:** Renew System  
**Qty:** 65,259.00  
**Unit of Measure:** S.F.  
**Estimate:** \$770,970.00  
**Assessor Name:** Eduardo Lopez  
**Date Created:** 01/19/2017

**Notes:** The acoustical ceiling tiles are beyond their service life and should be replaced.

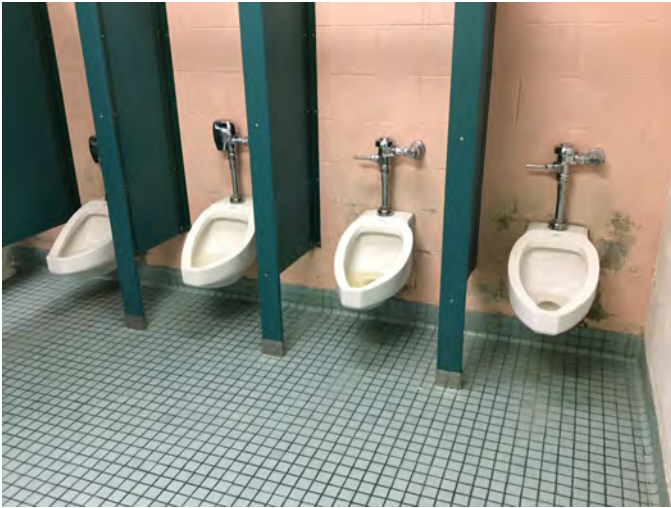
**System: D2010 - Plumbing Fixtures**

**Location:** Throughout Building  
**Distress:** Beyond Service Life  
**Category:** Deferred Maintenance  
**Priority:** 3 - Necessary/Not Yet Critical (Years 2-5)  
**Correction:** Renew System  
**Qty:** 65,259.00  
**Unit of Measure:** S.F.  
**Estimate:** \$808,298.00  
**Assessor Name:** Eduardo Lopez  
**Date Created:** 01/19/2017

**Notes:** The plumbing fixtures are beyond their service life and should be replaced.

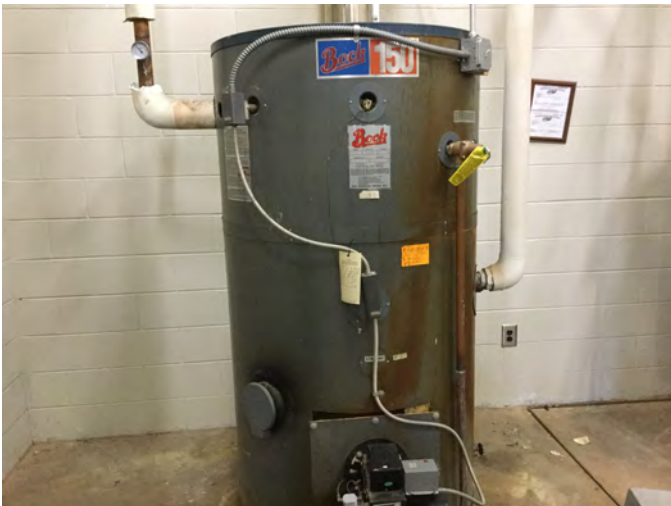
**System: D2020 - Domestic Water Distribution**

**Location:** Throughout Building  
**Distress:** Beyond Service Life  
**Category:** Deferred Maintenance  
**Priority:** 3 - Necessary/Not Yet Critical (Years 2-5)  
**Correction:** Renew System  
**Qty:** 65,259.00  
**Unit of Measure:** S.F.  
**Estimate:** \$68,914.00  
**Assessor Name:** Eduardo Lopez  
**Date Created:** 01/19/2017

**Notes:** The domestic water distribution system is beyond its service life and should be replaced.

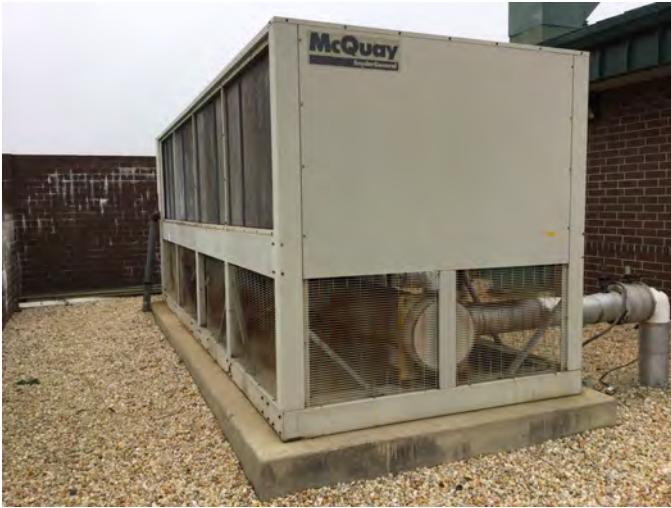
**System: D3030 - Cooling Generating Systems**

**Location:** Throughout Building  
**Distress:** Beyond Service Life  
**Category:** Deferred Maintenance  
**Priority:** 3 - Necessary/Not Yet Critical (Years 2-5)  
**Correction:** Renew System  
**Qty:** 65,259.00  
**Unit of Measure:** S.F.  
**Estimate:** \$370,410.00  
**Assessor Name:** Eduardo Lopez  
**Date Created:** 01/19/2017

**Notes:** The cooling system is beyond its service life and should be replaced.

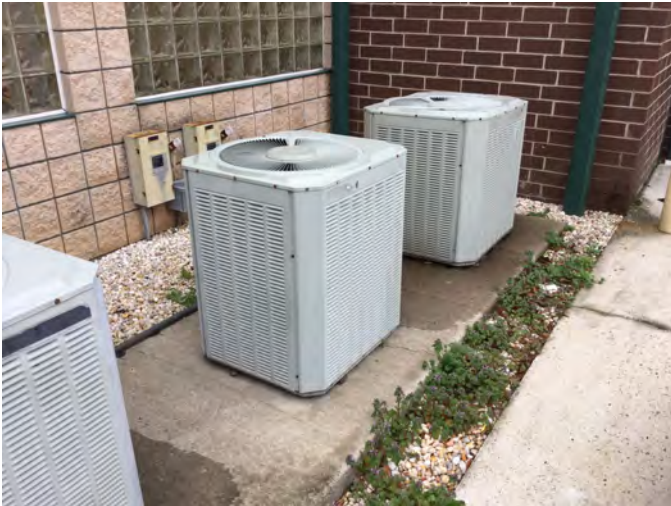
**System: D3050 - Terminal & Package Units**

**Location:** Throughout Building  
**Distress:** Beyond Service Life  
**Category:** Deferred Maintenance  
**Priority:** 3 - Necessary/Not Yet Critical (Years 2-5)  
**Correction:** Renew System  
**Qty:** 65,259.00  
**Unit of Measure:** S.F.  
**Estimate:** \$212,483.00  
**Assessor Name:** Eduardo Lopez  
**Date Created:** 01/16/2017

**Notes:** The terminal and package units are beyond their service life and should be replaced.

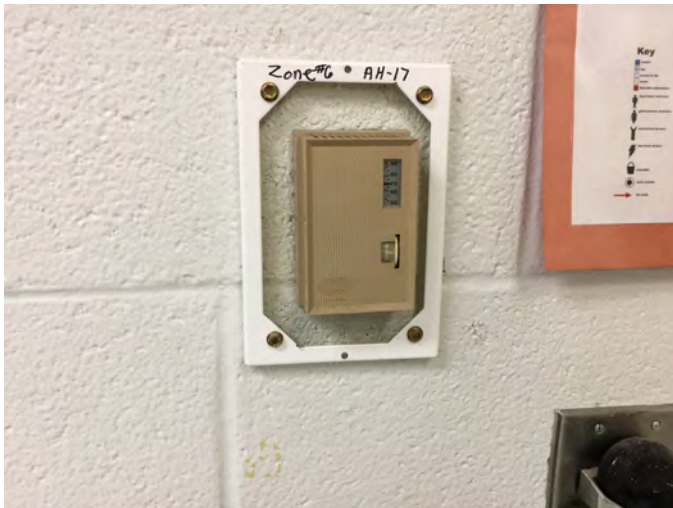
**System: D3060 - Controls & Instrumentation**

**Location:** Throughout Building  
**Distress:** Beyond Service Life  
**Category:** Deferred Maintenance  
**Priority:** 3 - Necessary/Not Yet Critical (Years 2-5)  
**Correction:** Renew System  
**Qty:** 65,259.00  
**Unit of Measure:** S.F.  
**Estimate:** \$137,109.00  
**Assessor Name:** Eduardo Lopez  
**Date Created:** 01/16/2017

**Notes:** The controls and instrumentation are beyond its service life and should be replaced.

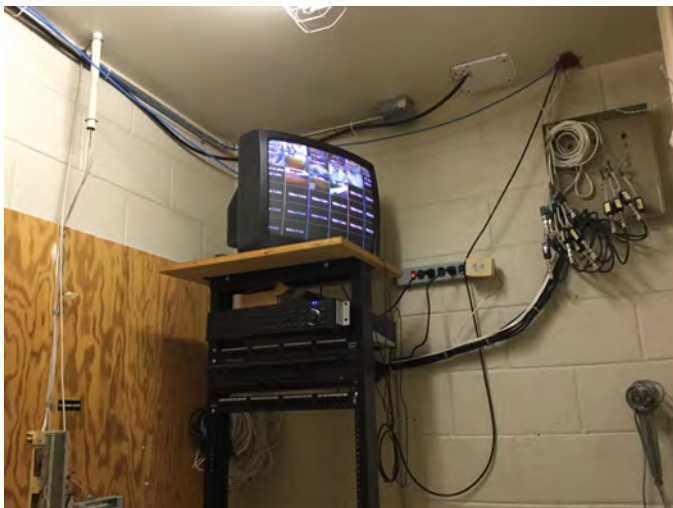
**System: D5030810 - Security & Detection Systems**

**Location:** Throughout Building  
**Distress:** Beyond Service Life  
**Category:** Deferred Maintenance  
**Priority:** 3 - Necessary/Not Yet Critical (Years 2-5)  
**Correction:** Renew System  
**Qty:** 65,259.00  
**Unit of Measure:** S.F.  
**Estimate:** \$131,366.00  
**Assessor Name:** Eduardo Lopez  
**Date Created:** 01/16/2017

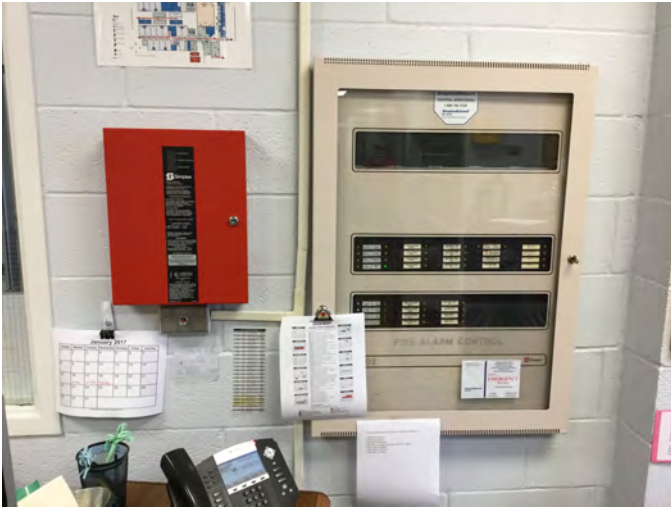
**System: D5030910 - Fire Alarm Systems**

**Location:** Throughout Building  
**Distress:** Beyond Service Life  
**Category:** Deferred Maintenance  
**Priority:** 3 - Necessary/Not Yet Critical (Years 2-5)  
**Correction:** Renew System  
**Qty:** 65,259.00  
**Unit of Measure:** S.F.  
**Estimate:** \$237,608.00  
**Assessor Name:** Eduardo Lopez  
**Date Created:** 01/16/2017

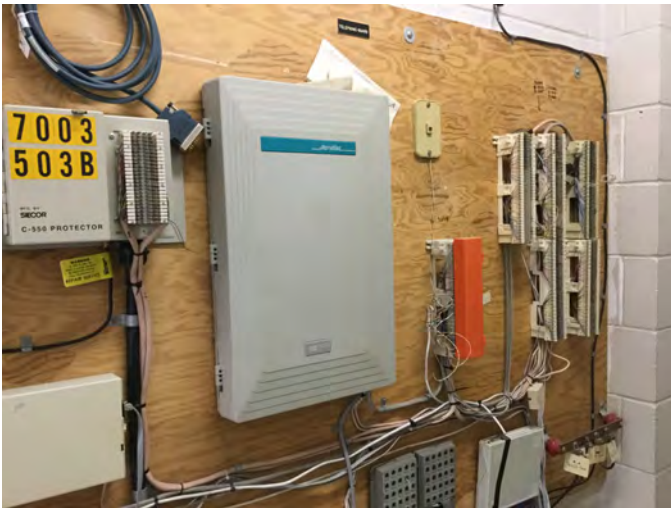
**System: D5030920 - Data Communication**

**Location:** Throughout Building  
**Distress:** Beyond Service Life  
**Category:** Deferred Maintenance  
**Priority:** 3 - Necessary/Not Yet Critical (Years 2-5)  
**Correction:** Renew System  
**Qty:** 65,259.00  
**Unit of Measure:** S.F.  
**Estimate:** \$308,675.00  
**Assessor Name:** Eduardo Lopez  
**Date Created:** 01/16/2017

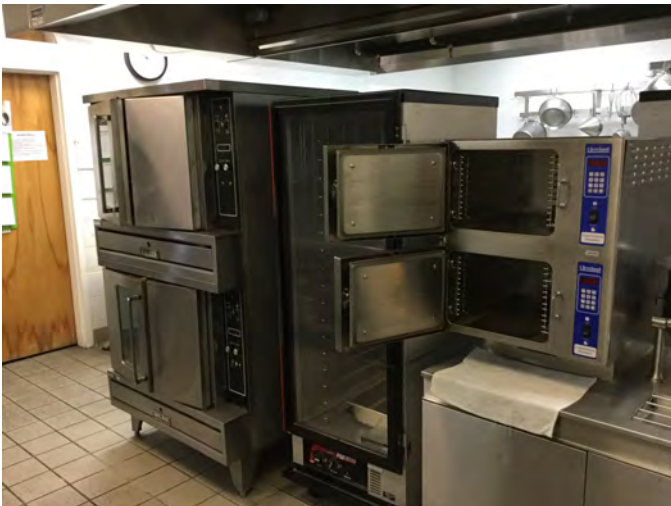
**System: E1090 - Other Equipment**

**Location:** Kitchen  
**Distress:** Beyond Service Life  
**Category:** Deferred Maintenance  
**Priority:** 3 - Necessary/Not Yet Critical (Years 2-5)  
**Correction:** Renew System  
**Qty:** 65,259.00  
**Unit of Measure:** S.F.  
**Estimate:** \$133,520.00  
**Assessor Name:** Eduardo Lopez  
**Date Created:** 01/16/2017

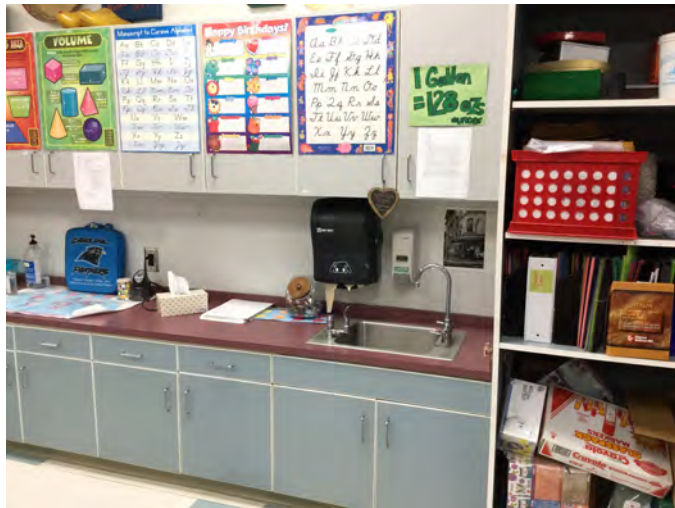
**System: E2010 - Fixed Furnishings**

**Location:** Throughout Building  
**Distress:** Beyond Service Life  
**Category:** Deferred Maintenance  
**Priority:** 3 - Necessary/Not Yet Critical (Years 2-5)  
**Correction:** Renew System  
**Qty:** 65,259.00  
**Unit of Measure:** S.F.  
**Estimate:** \$410,610.00  
**Assessor Name:** Eduardo Lopez  
**Date Created:** 01/16/2017

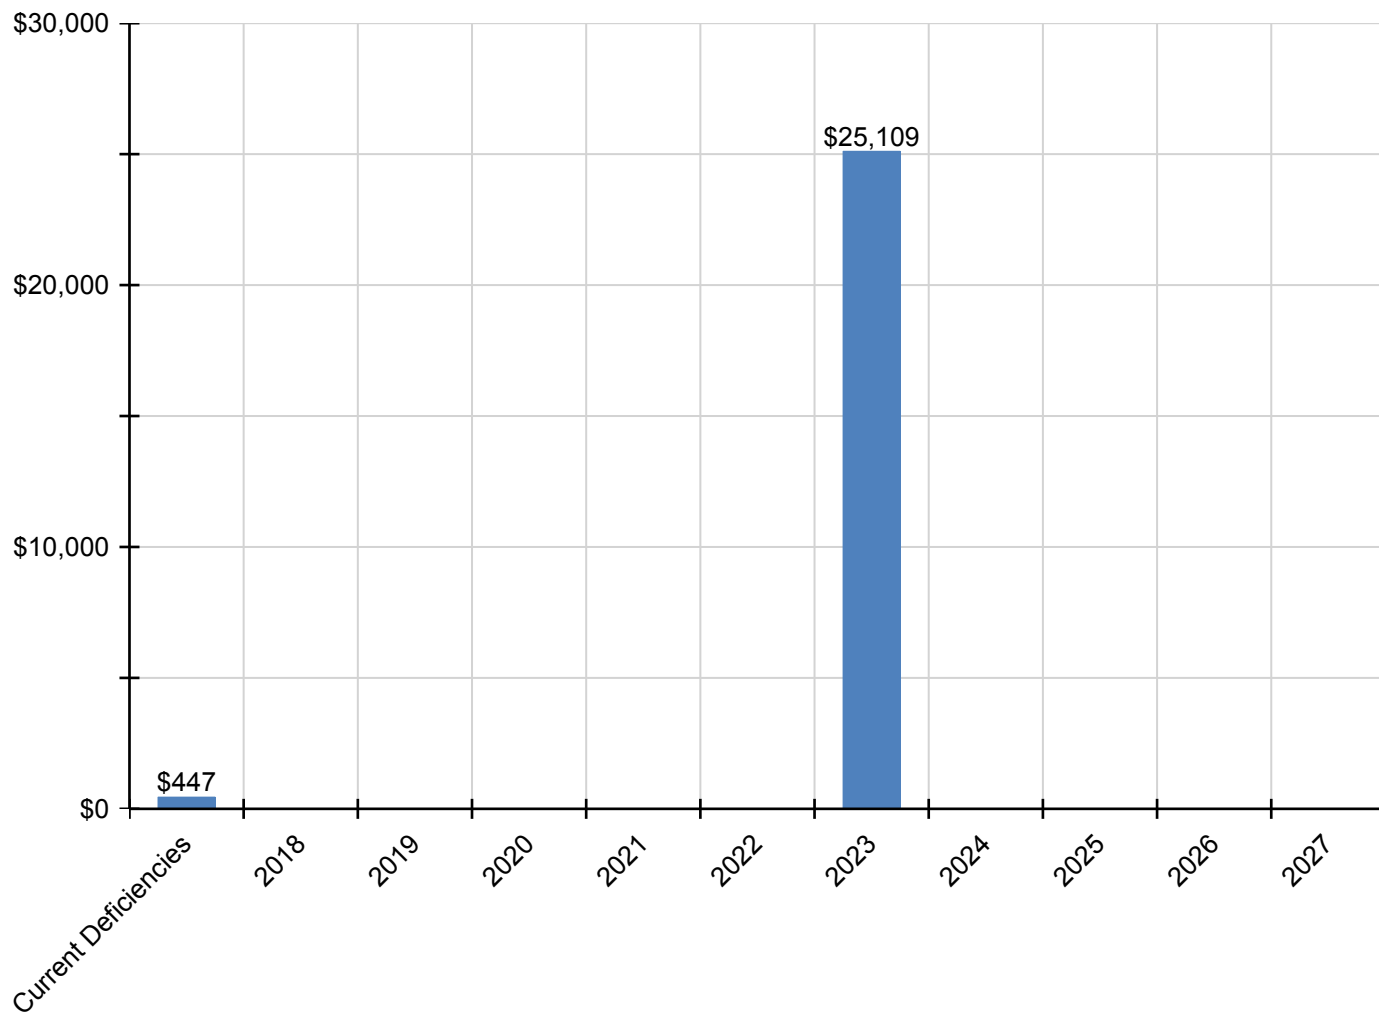
## Forecasted Capital Renewal Requirement

The following chart shows the current building deficiencies and forecasting capital renewal or sustainment requirements over the next ten years.

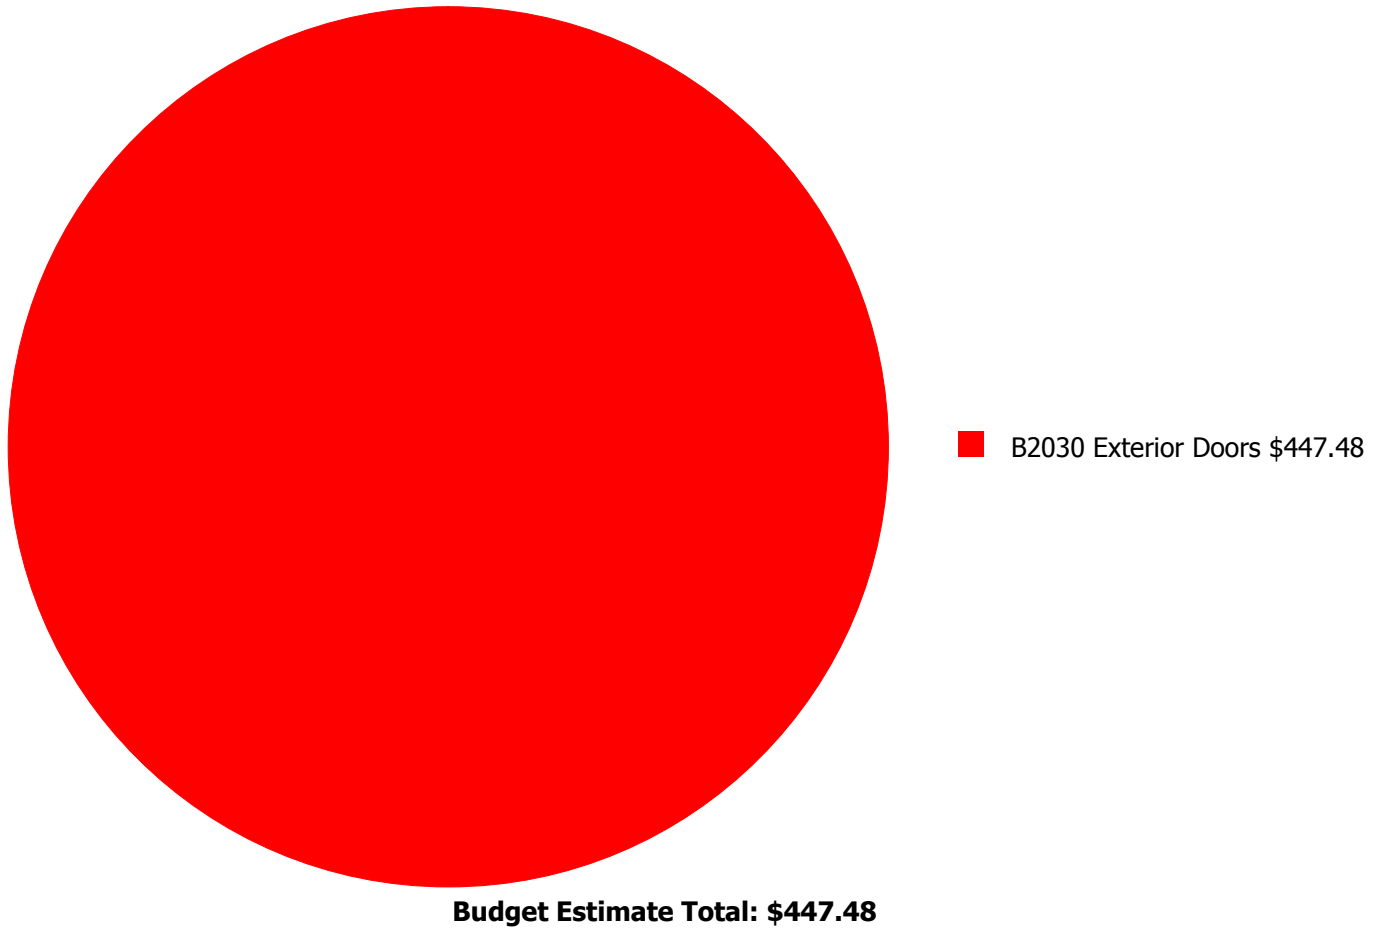
## Deficiency Summary by System

Current deficiencies included assemblies that have reached or exceeded their design life or components of the assemblies that are in need of repair. Assemblies that have reached their design life are identified as current deficiencies and assigned the distress 'Beyond Useful Life'. The following chart lists all current deficiencies associated with this facility.

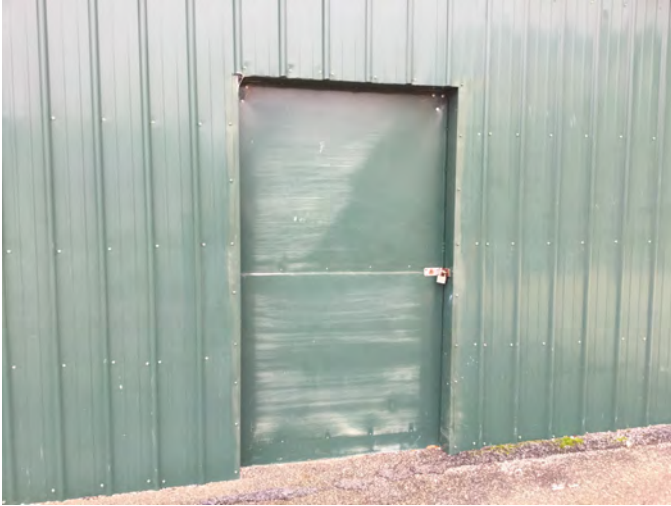
#### **System: B2030 - Exterior Doors**

**Location:** Exterior Walls  
**Distress:** Damaged  
**Category:** Deferred Maintenance / Appearance  
**Priority:** 3 - Necessary/Not Yet Critical (Years 2-5)  
**Correction:** Refinish 3'-0" x 7'-0" steel sliding painted door  
**Qty:** 3.00  
**Unit of Measure:** Ea.  
**Estimate:** \$447.48  
**Assessor Name:** Eduardo Lopez  
**Date Created:** 01/18/2017

**Notes:** The exterior doors are scuffed up and need to be refinished.

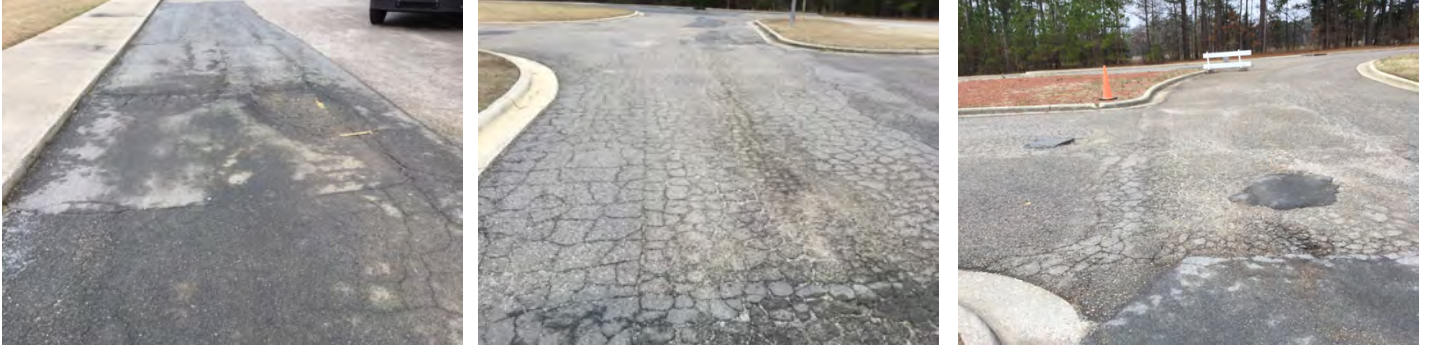
**System:** G2010 - Roadways

**Note:** The roadways are in poor condition and should be repaved.

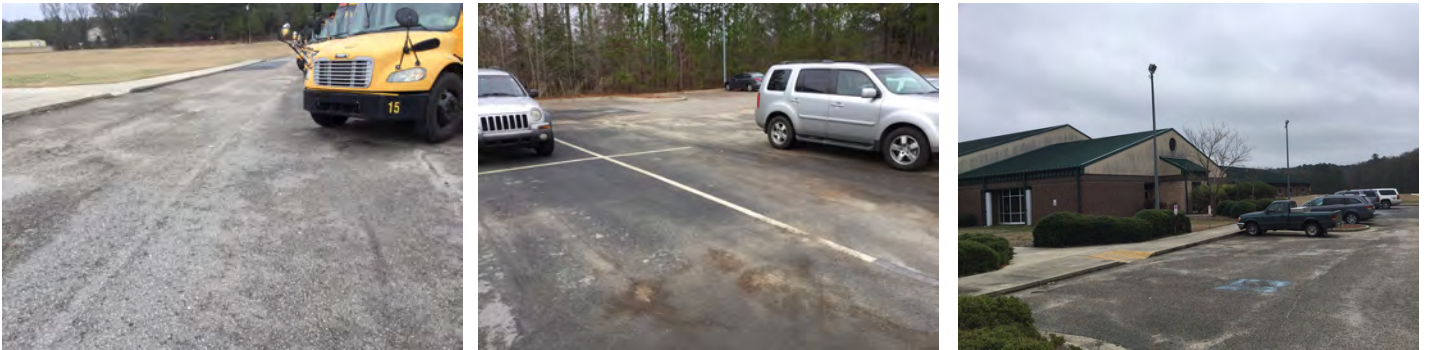
**System:** G2020 - Parking Lots

**Note:** The parking lot needs to be repaved, resealed, and restriped. The ADA parking needs to be brought up to the current codes.
