# Anson Middle

## Campus Assessment Report

March 7, 2017

## Campus Assessment Report - 1966 Building, Cafe/Gym

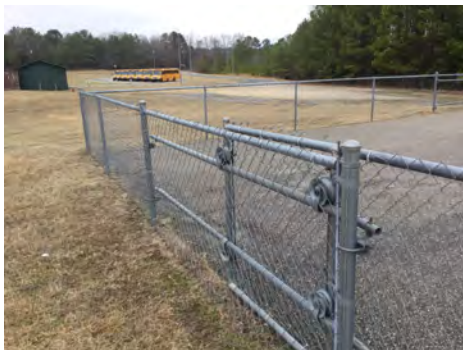
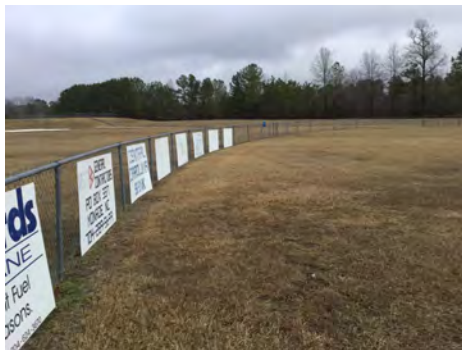
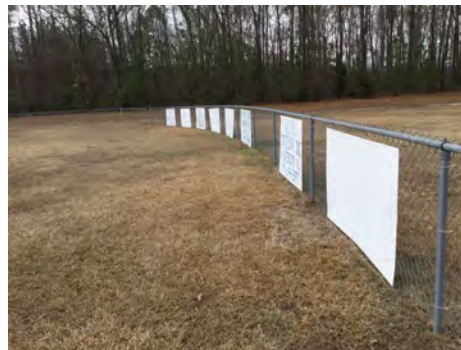
**System:** G2040105 - Fence & Guardrails

**Note:** The site does not have a site boundary fencing.

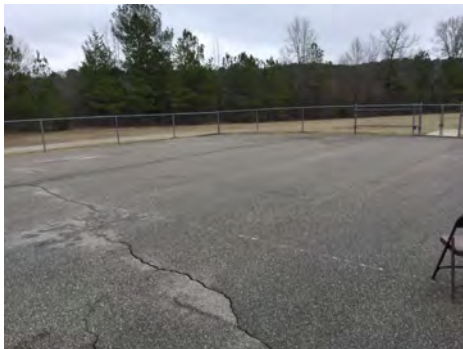
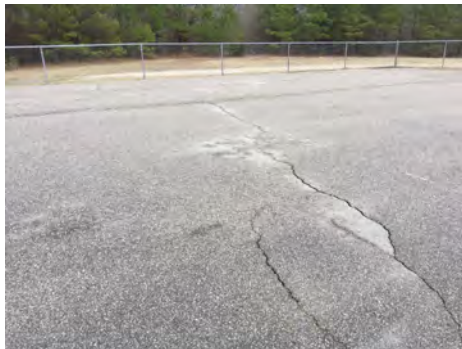
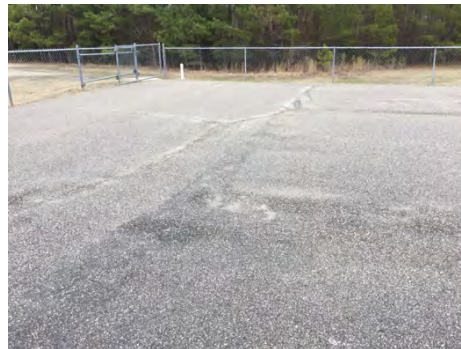
**System:** G2040950 - Hard Surface Play Area

**Note:** The hard surface play area is beyond its service life and should be replaced.

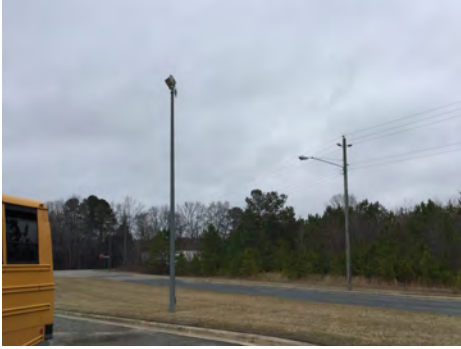
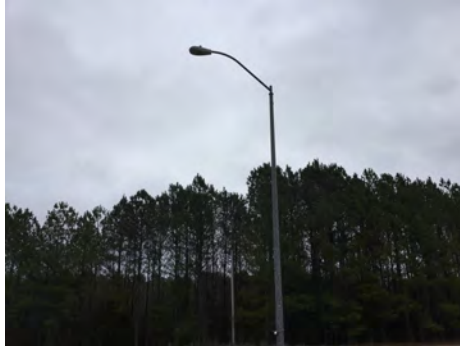
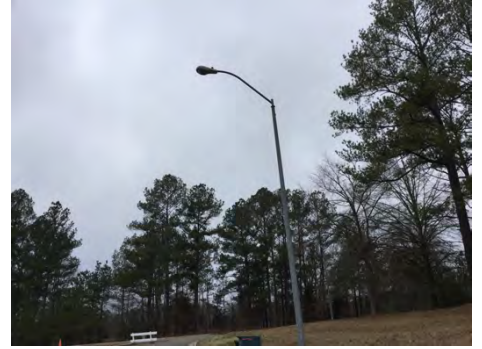
**System:** G4020 - Site Lighting

**Note:** The exterior lighting is considered inadequate and more lighting should be installed.

**Notes:** The exterior lighting is considered inadequate and more lighting should be installed.

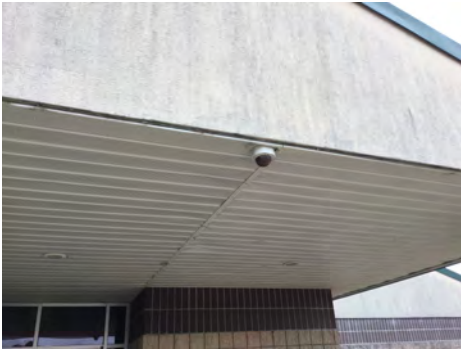
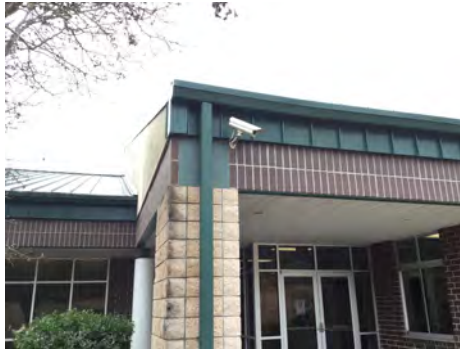
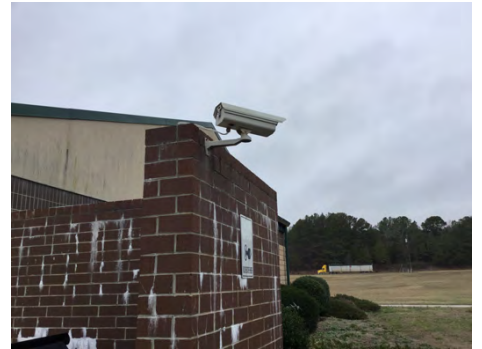
**System:** G4030 - Site Communications & Security

**Note:** The site security system is beyond its service life and should be replaced.

**Notes:** The site security system is beyond its service life and should be replaced.

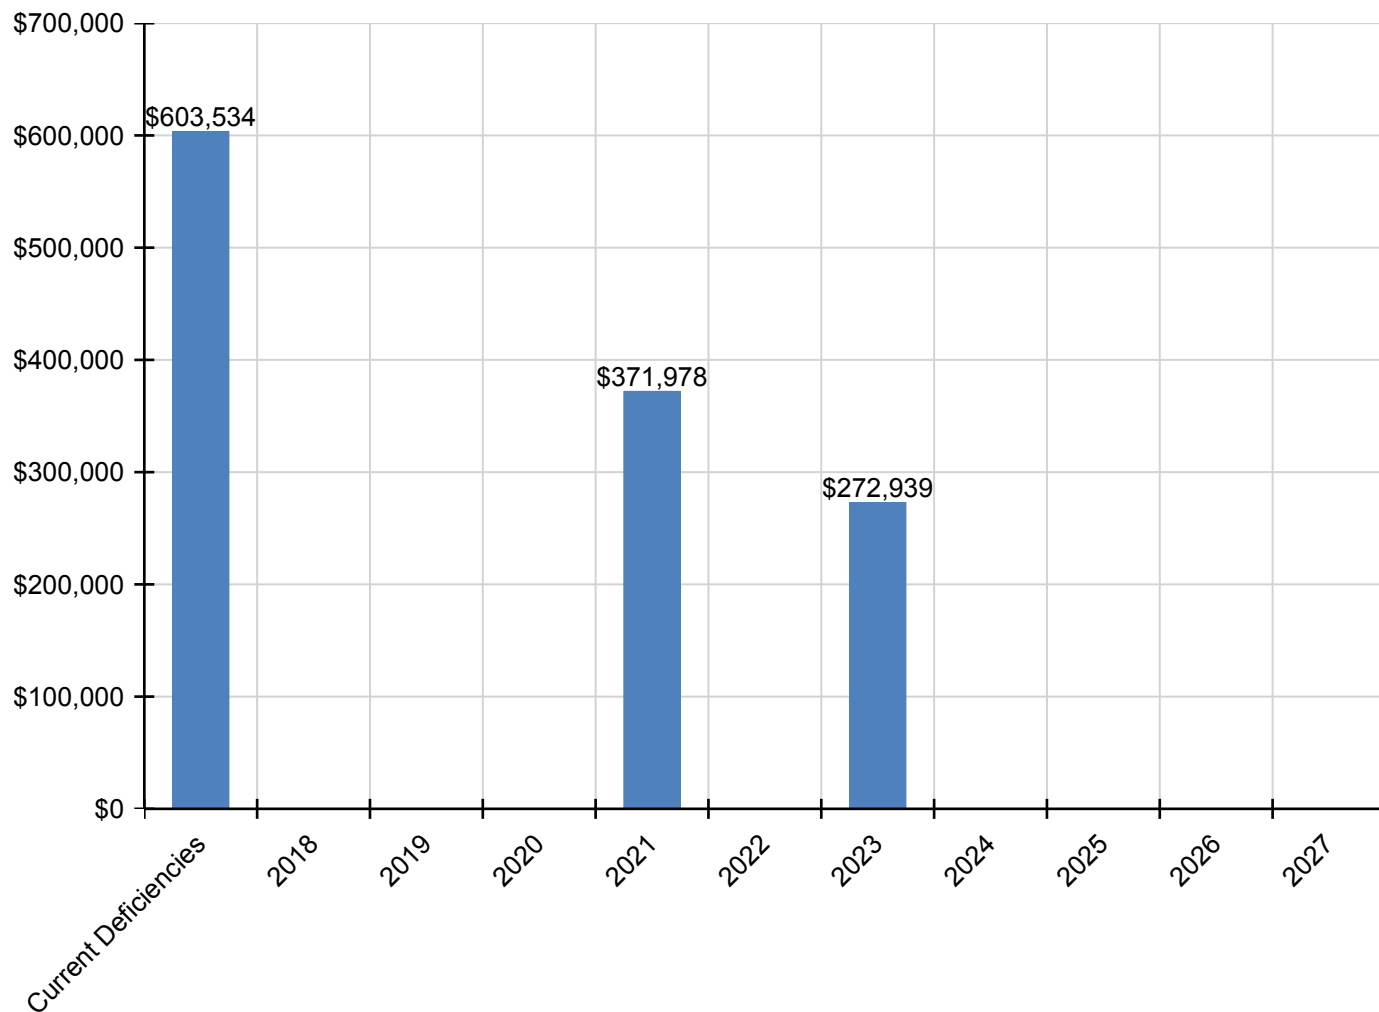
## Forecasted Capital Renewal Requirement

The following chart shows the current building deficiencies and forecasting capital renewal or sustainment requirements over the next ten years.

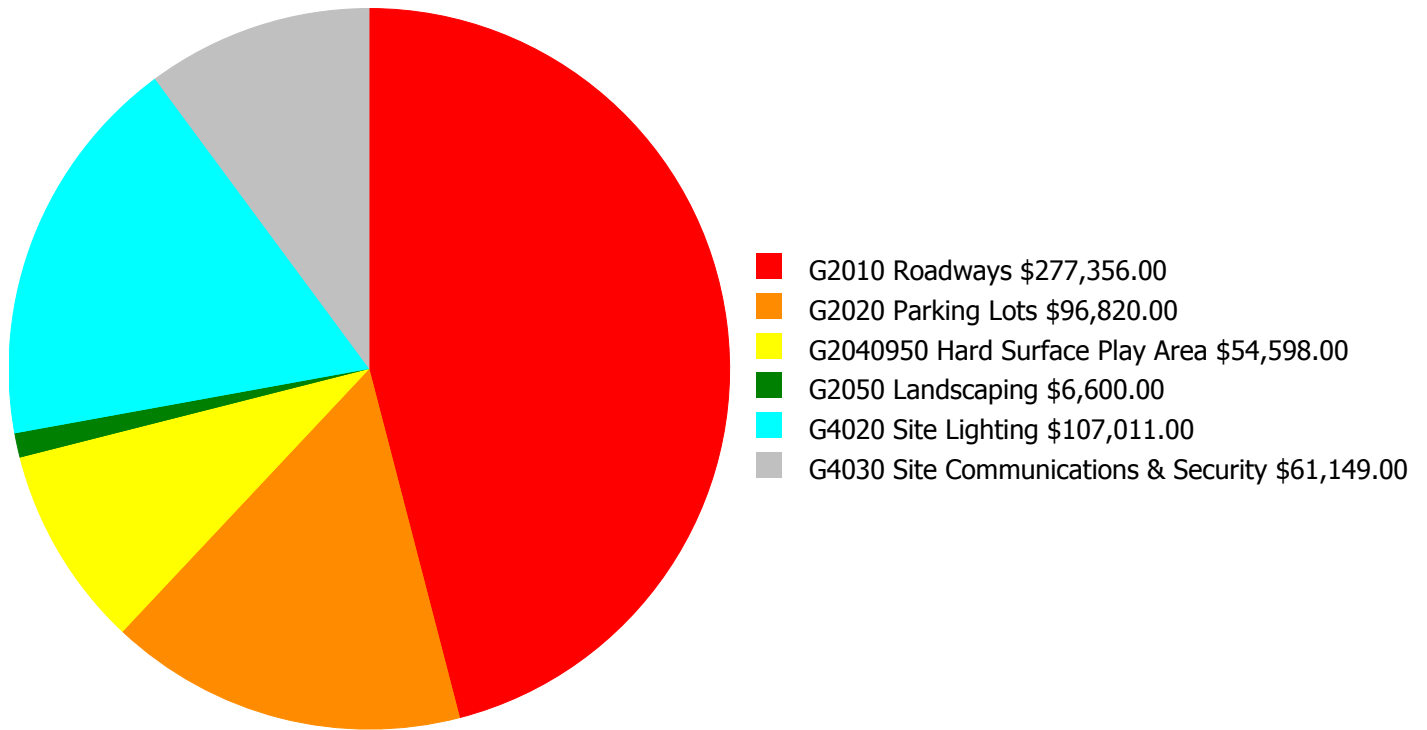
## Deficiency Summary by System

Current deficiencies included assemblies that have reached or exceeded their design life or components of the assemblies that are in need of repair. Assemblies that have reached their design life are identified as current deficiencies and assigned the distress 'Beyond Useful Life'. The following chart lists all current deficiencies associated with this facility.

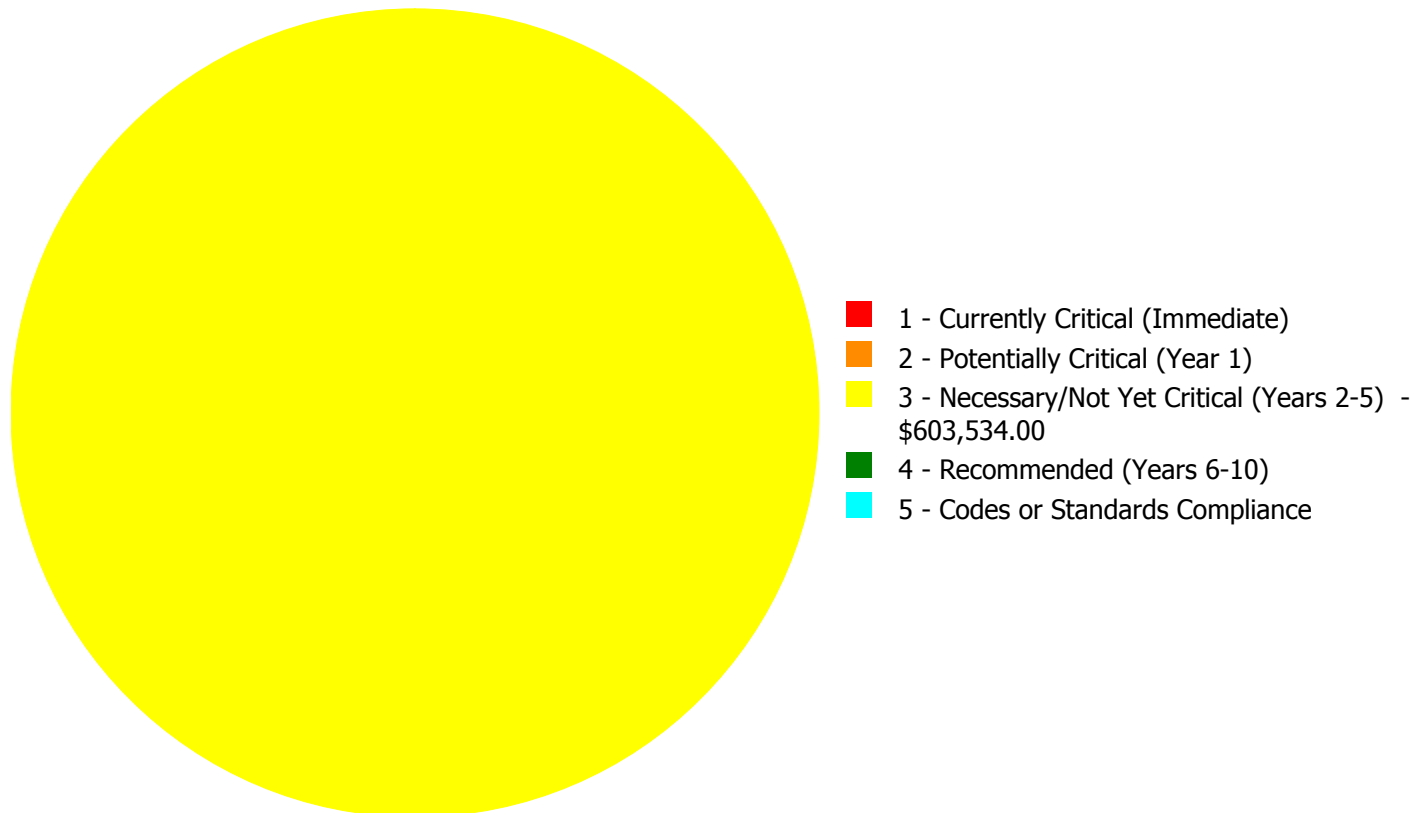
## Deficiency Summary by Priority

The following chart shows the total repair costs broken down by priority. Assessors assigned deficiencies within eCOMET to one of the following priority categories:

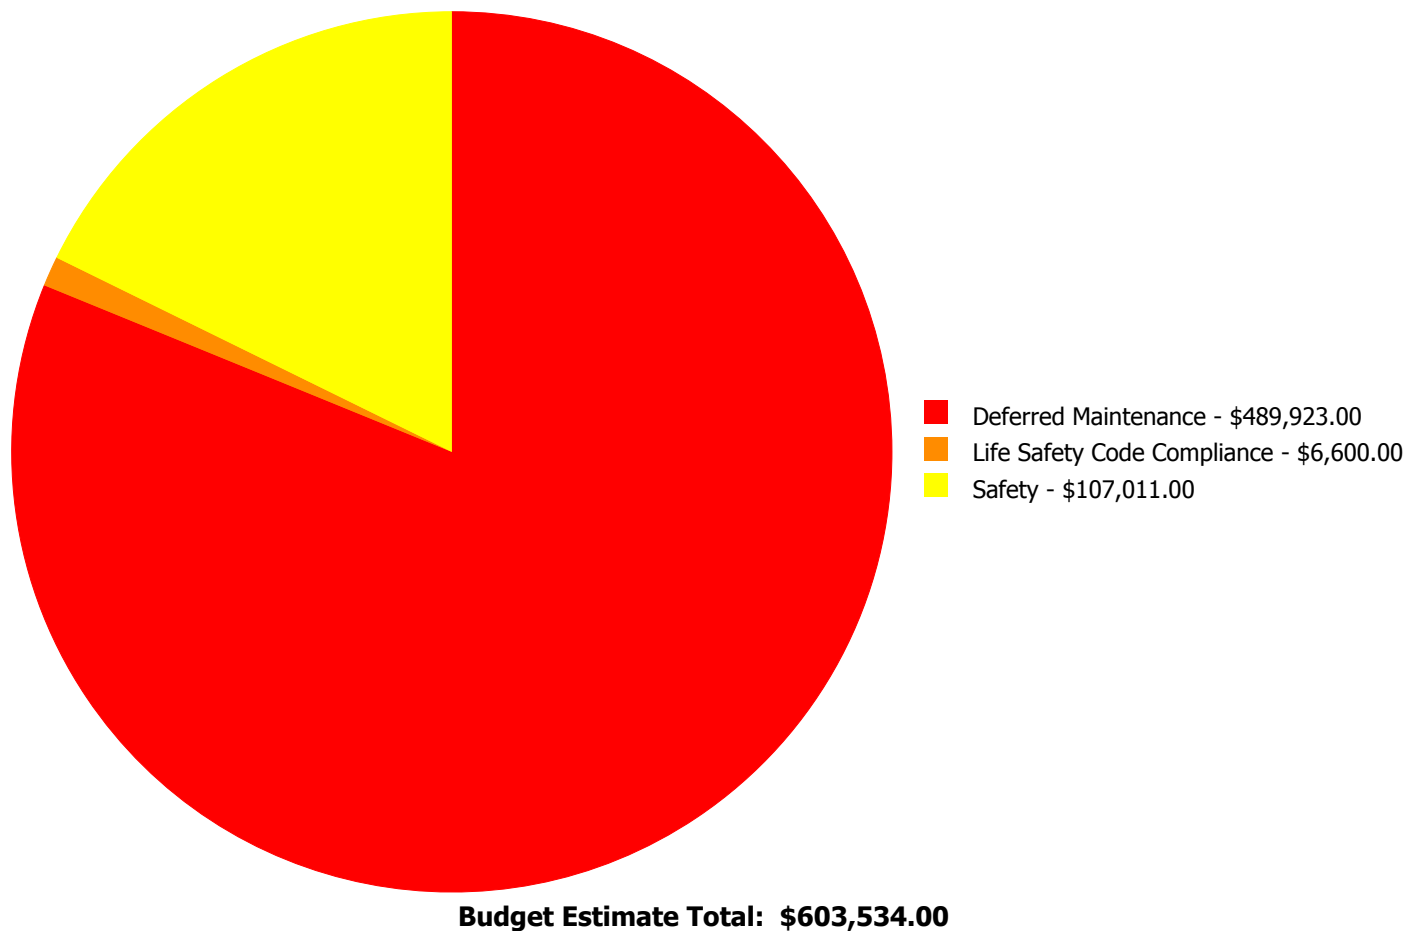
## Deficiency Summary by Category

The following chart shows the total repair costs broken down by deficiency categories. Assessors assigned deficiencies to one of the following categories:

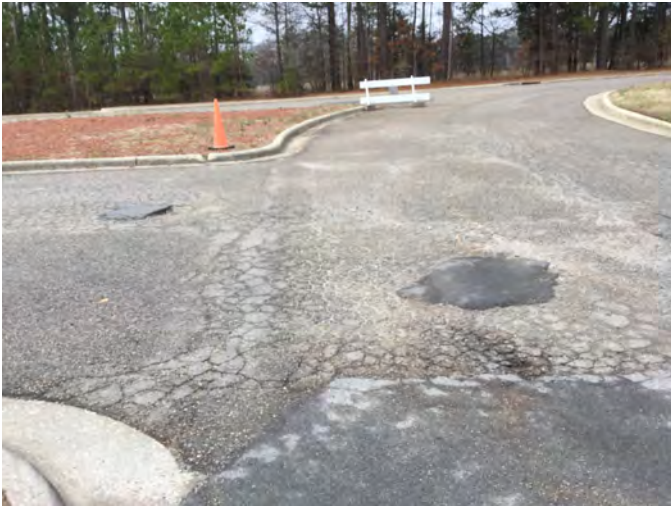
#### System: G2010 - Roadways

**Location:** Site  
**Distress:** Beyond Service Life  
**Category:** Deferred Maintenance  
**Priority:** 3 - Necessary/Not Yet Critical (Years 2-5)  
**Correction:** Renew System  
**Qty:** 66,179.00  
**Unit of Measure:** S.F.  
**Estimate:** \$277,356.00  
**Assessor Name:** Eduardo Lopez  
**Date Created:** 01/19/2017

**Notes:** The roadways are in poor condition and should be repaved.

**Note:** The roadways are in poor condition and should be repaved.

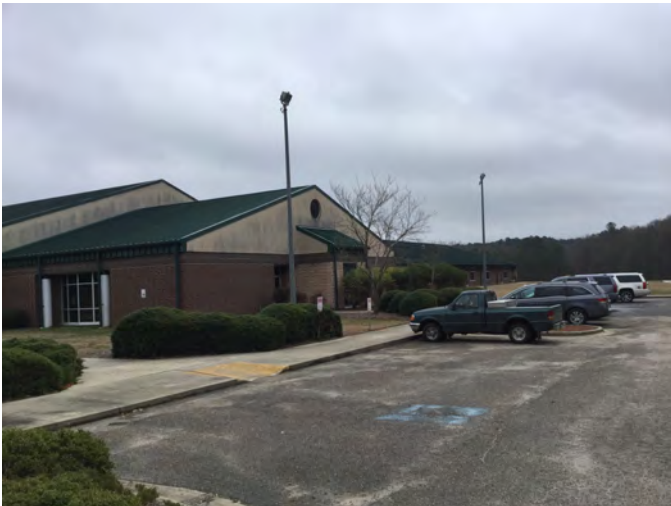
#### System: G2020 - Parking Lots

**Location:** Site  
**Distress:** Beyond Service Life  
**Category:** Deferred Maintenance  
**Priority:** 3 - Necessary/Not Yet Critical (Years 2-5)  
**Correction:** Renew System  
**Qty:** 66,179.00  
**Unit of Measure:** S.F.  
**Estimate:** \$96,820.00  
**Assessor Name:** Eduardo Lopez  
**Date Created:** 01/19/2017

**Notes:** The parking lot needs to be repaved, resealed, and restriped. The ADA parking needs to be brought up to the current codes.

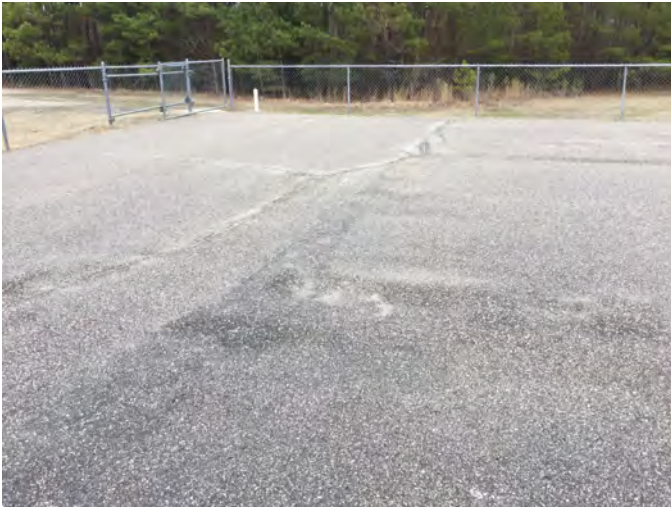
**System: G2040950 - Hard Surface Play Area**

**Location:** Site  
**Distress:** Beyond Service Life  
**Category:** Deferred Maintenance  
**Priority:** 3 - Necessary/Not Yet Critical (Years 2-5)  
**Correction:** Renew System  
**Qty:** 66,179.00  
**Unit of Measure:** S.F.  
**Estimate:** \$54,598.00  
**Assessor Name:** Eduardo Lopez  
**Date Created:** 01/16/2017

**Notes:** The hard surface play area is beyond its service life and should be replaced.

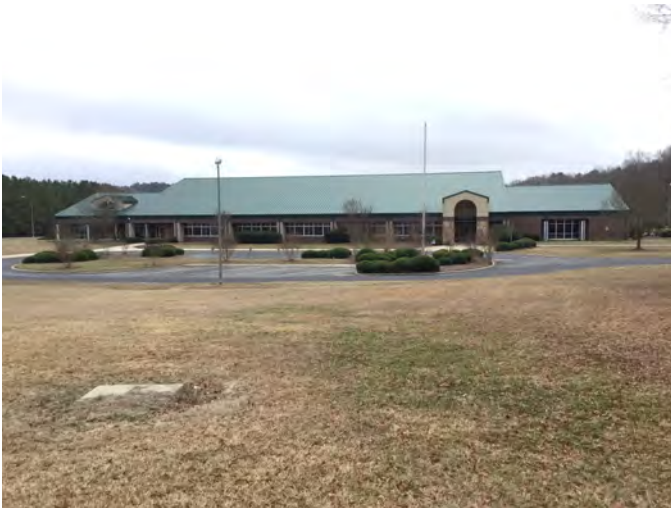
**System: G2050 - Landscaping**

**Location:** Site  
**Distress:** Failing  
**Category:** Life Safety Code Compliance  
**Priority:** 3 - Necessary/Not Yet Critical (Years 2-5)  
**Correction:** Grading study  
**Qty:** 1.00  
**Unit of Measure:** Ea.  
**Estimate:** \$6,600.00  
**Assessor Name:** Eduardo Lopez  
**Date Created:** 01/18/2017

**Notes:** The storm water is not reaching the storm drainage system, a grading study needs to be conducted to understand the problem.

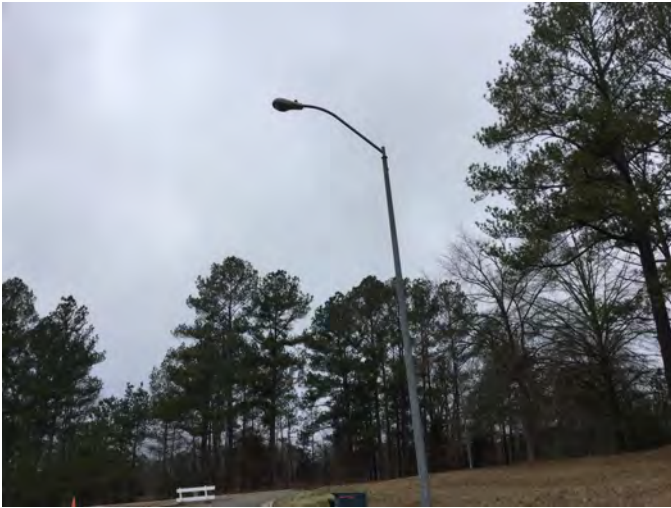
**System: G4020 - Site Lighting**

**Location:** Site  
**Distress:** Inadequate  
**Category:** Safety  
**Priority:** 3 - Necessary/Not Yet Critical (Years 2-5)  
**Correction:** Renew System  
**Qty:** 66,179.00  
**Unit of Measure:** S.F.  
**Estimate:** \$107,011.00  
**Assessor Name:** Eduardo Lopez  
**Date Created:** 01/19/2017

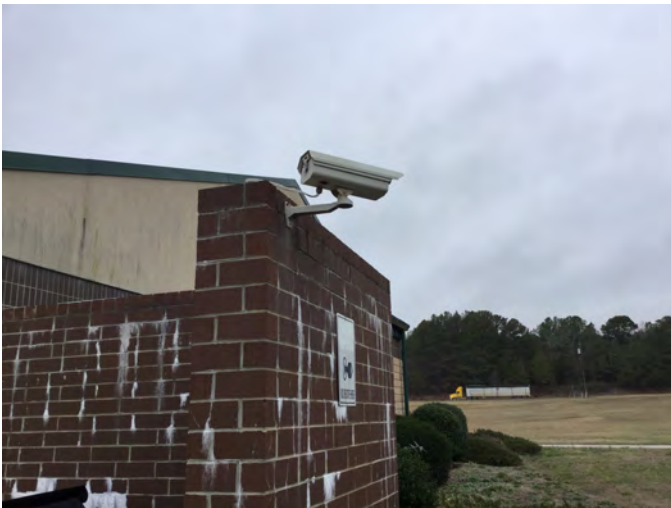
**System: G4030 - Site Communications & Security**

**Location:** Site  
**Distress:** Beyond Service Life  
**Category:** Deferred Maintenance  
**Priority:** 3 - Necessary/Not Yet Critical (Years 2-5)  
**Correction:** Renew System  
**Qty:** 66,179.00  
**Unit of Measure:** S.F.  
**Estimate:** \$61,149.00  
**Assessor Name:** Eduardo Lopez  
**Date Created:** 01/19/2017

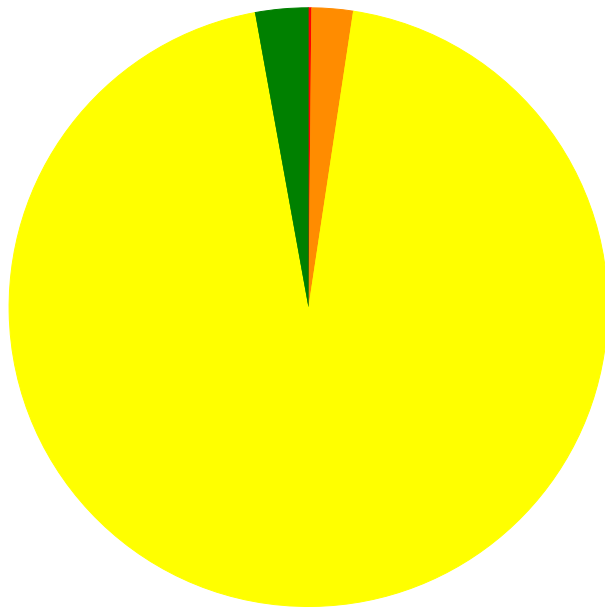
### Deficiencies By Priority

- 1 - Currently Critical (Immediate) - \$13,200.00
- 2 - Potentially Critical (Year 1) - \$187,881.00
- 3 - Necessary/Not Yet Critical (Years 2-5) - \$7,987,402.12
- 4 - Recommended (Years 6-10) - \$240,660.00
- 5 - Codes or Standards Compliance

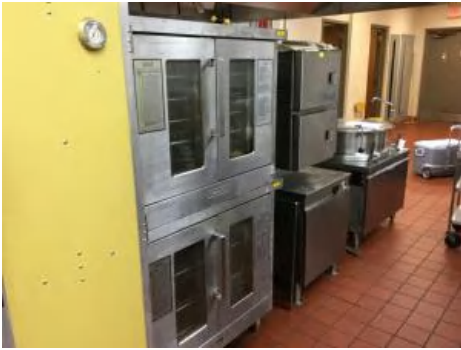
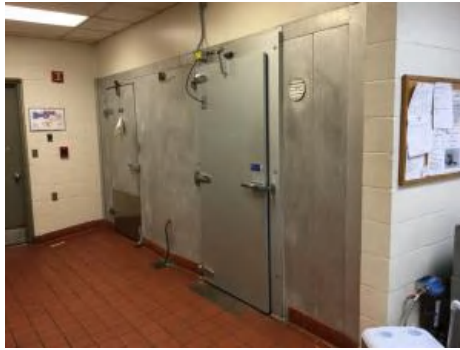
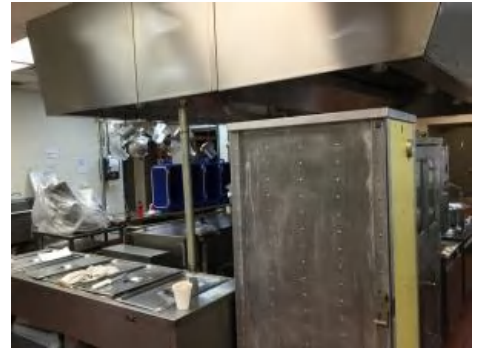
**System:** E1090 - Other Equipment

**Note:** Kitchen equipment is generally well beyond its expected useful life. System renewal is recommended.

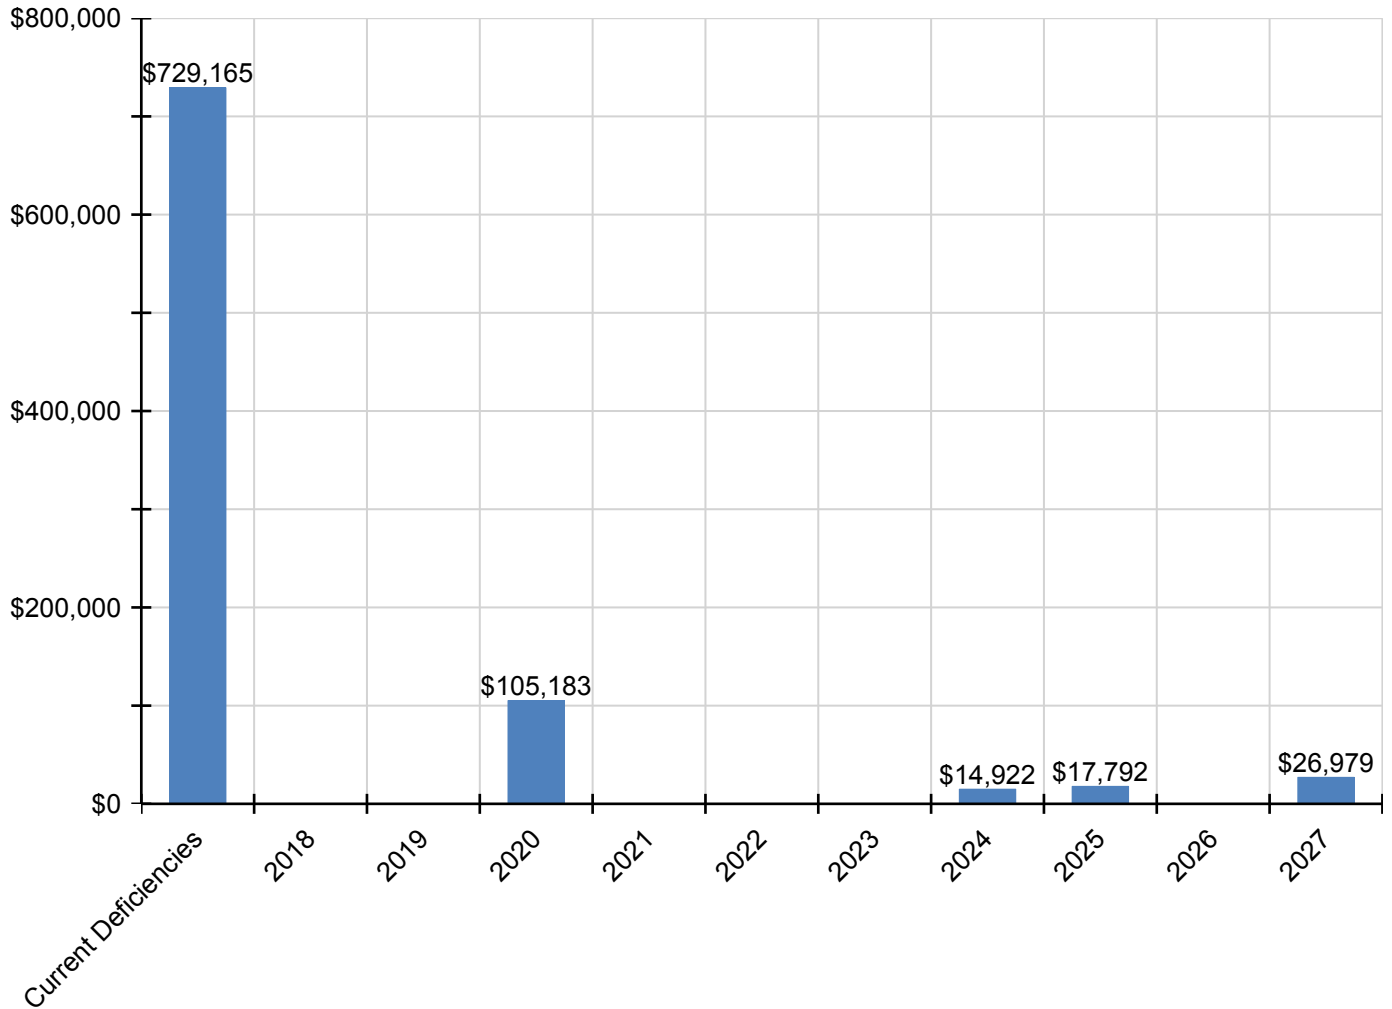
## Forecasted Capital Renewal Requirement

The following chart shows the current building deficiencies and forecasting capital renewal or sustainment requirements over the next ten years.

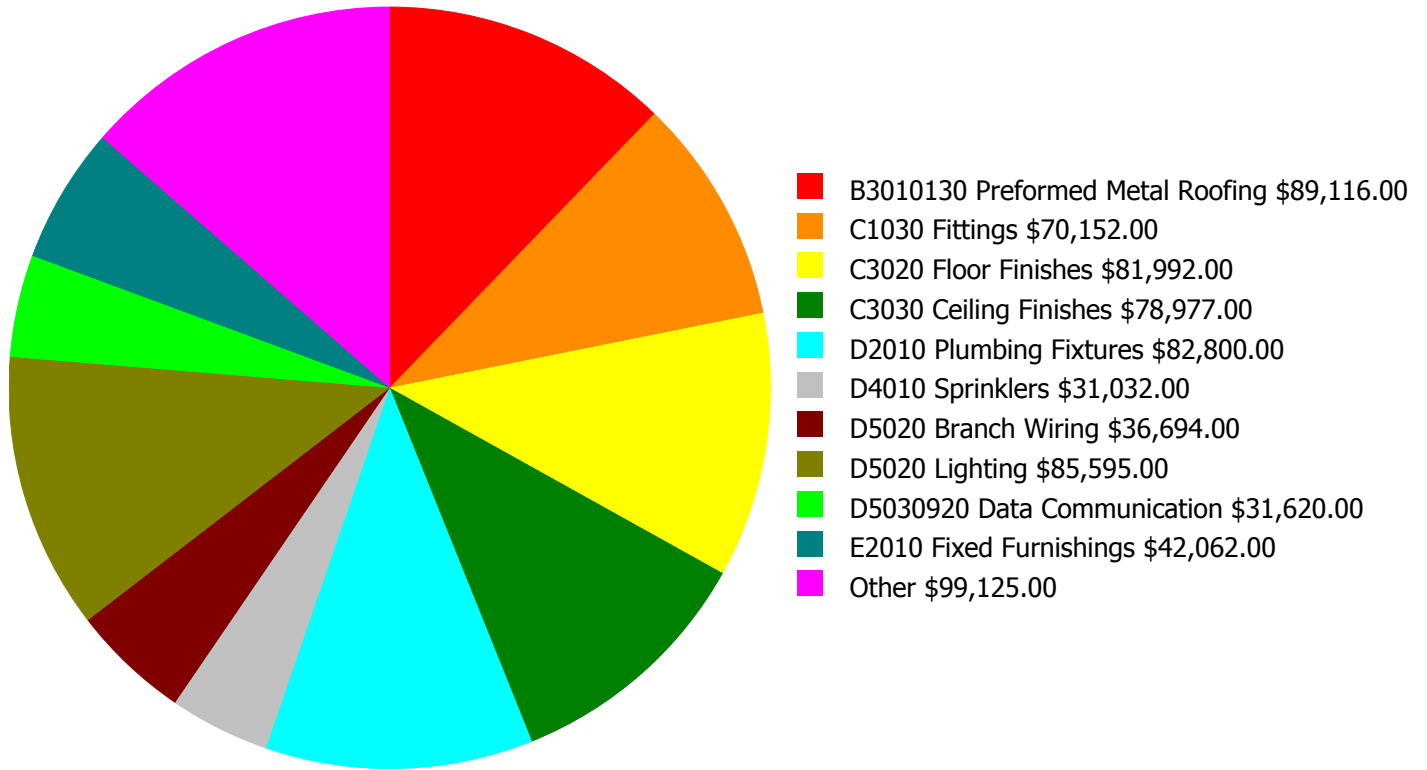
### Deficiency Summary by System

Current deficiencies included assemblies that have reached or exceeded their design life or components of the assemblies that are in need of repair. Assemblies that have reached their design life are identified as current deficiencies and assigned the distress 'Beyond Useful Life'. The following chart lists all current deficiencies associated with this facility.

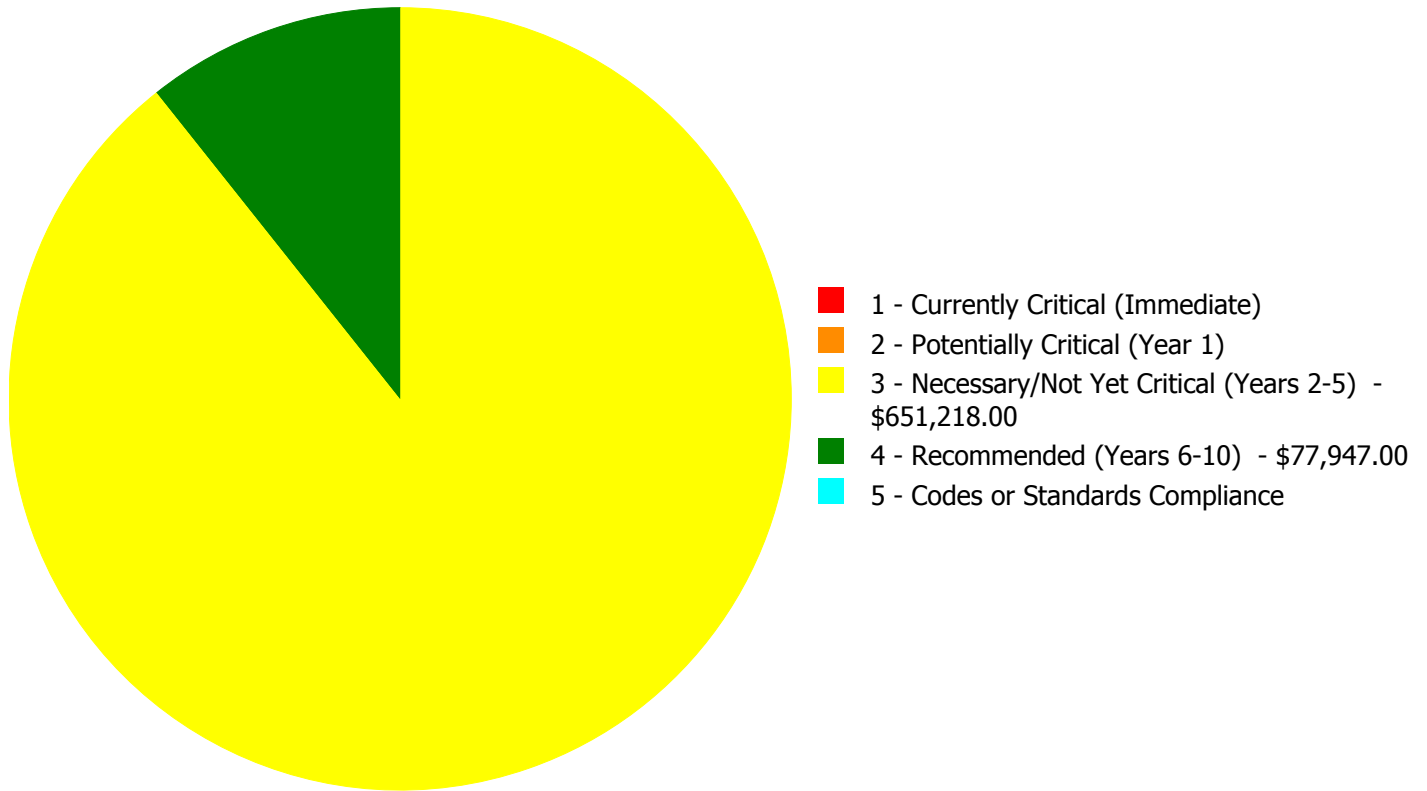
## Deficiency Summary by Priority

The following chart shows the total repair costs broken down by priority. Assessors assigned deficiencies within eCOMET to one of the following priority categories:

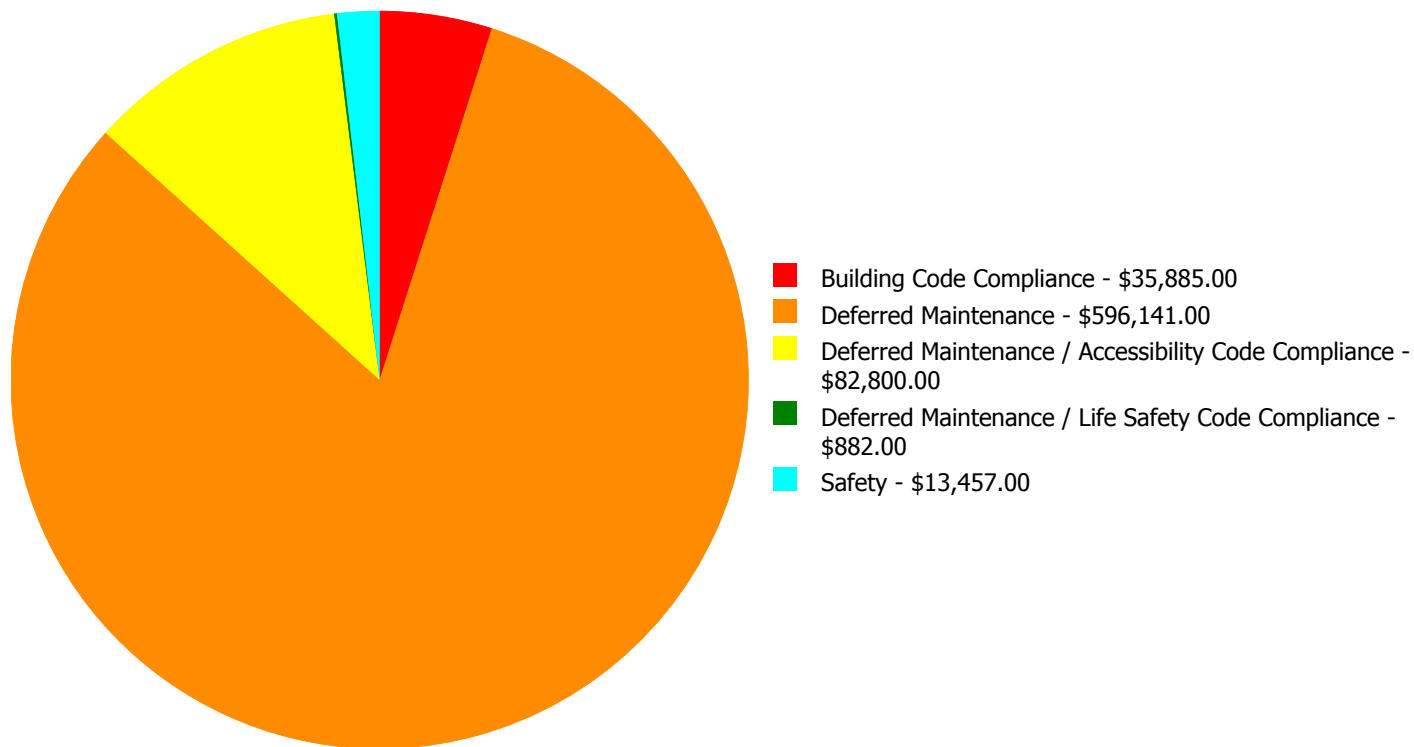
### Deficiency Summary by Category

The following chart shows the total repair costs broken down by deficiency categories. Assessors assigned deficiencies to one of the following categories:

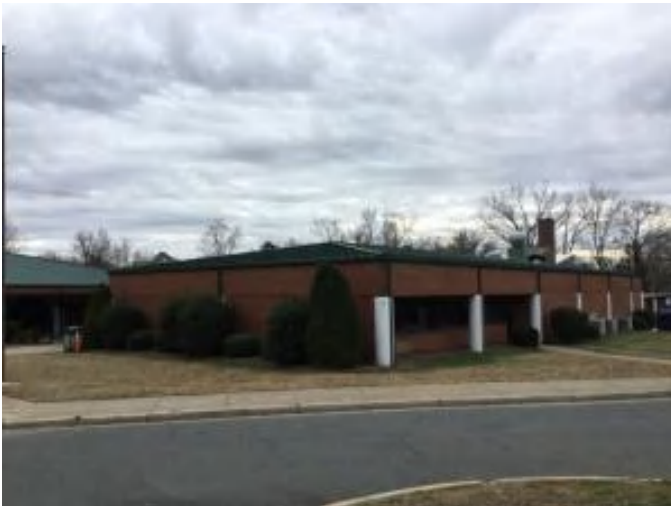
**System: B3010130 - Preformed Metal Roofing**

**Location:** Roof  
**Distress:** Beyond Service Life  
**Category:** Deferred Maintenance  
**Priority:** 3 - Necessary/Not Yet Critical (Years 2-5)  
**Correction:** Renew System  
**Qty:** 6,685.00  
**Unit of Measure:** S.F.  
**Estimate:** \$89,116.00  
**Assessor Name:** Somnath Das  
**Date Created:** 12/19/2016

**Notes:** The roof has exceeded its expected life. System renewal is recommended.

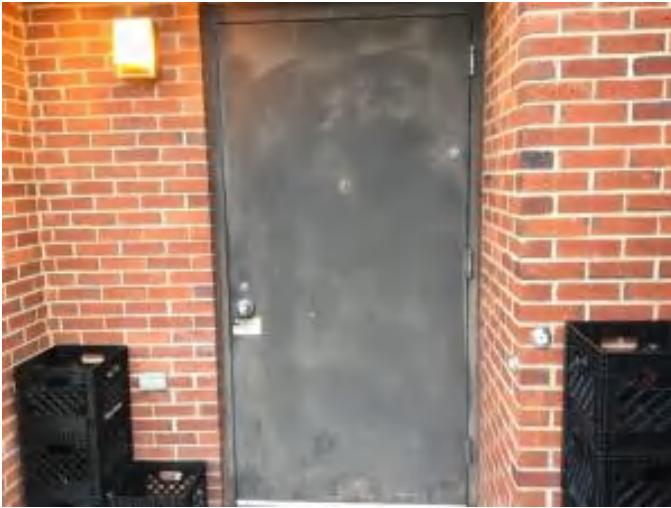
**System: C1020 - Interior Doors**

**Location:** Exterior doors  
**Distress:** Beyond Service Life  
**Category:** Deferred Maintenance  
**Priority:** 3 - Necessary/Not Yet Critical (Years 2-5)  
**Correction:** Renew System  
**Qty:** 6,685.00  
**Unit of Measure:** S.F.  
**Estimate:** \$18,237.00  
**Assessor Name:** Somnath Das  
**Date Created:** 12/19/2016

**Notes:** Exterior doors are beyond their expected service life. System renewal is recommended.

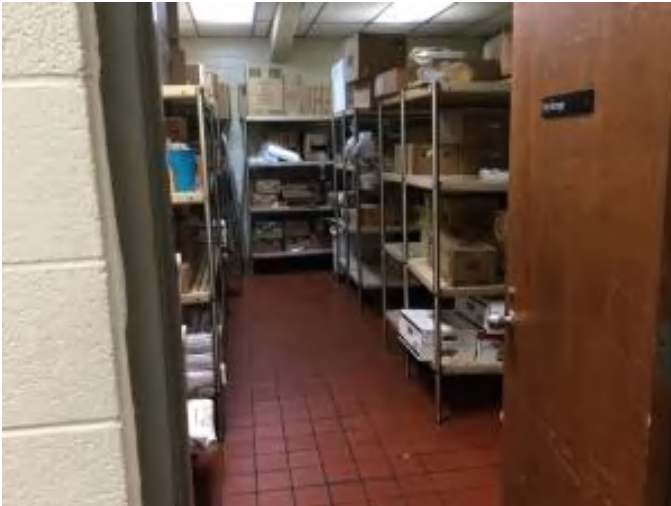
**System: C1030 - Fittings**

**Location:** Throughout the building  
**Distress:** Beyond Service Life  
**Category:** Deferred Maintenance  
**Priority:** 3 - Necessary/Not Yet Critical (Years 2-5)  
**Correction:** Renew System  
**Qty:** 6,685.00  
**Unit of Measure:** S.F.  
**Estimate:** \$70,152.00  
**Assessor Name:** Somnath Das  
**Date Created:** 12/19/2016

**Notes:** Fittings have exceed their expected useful life. Signage s not up to code. Toilet room is not ADA compliant. System renewal is recommended.

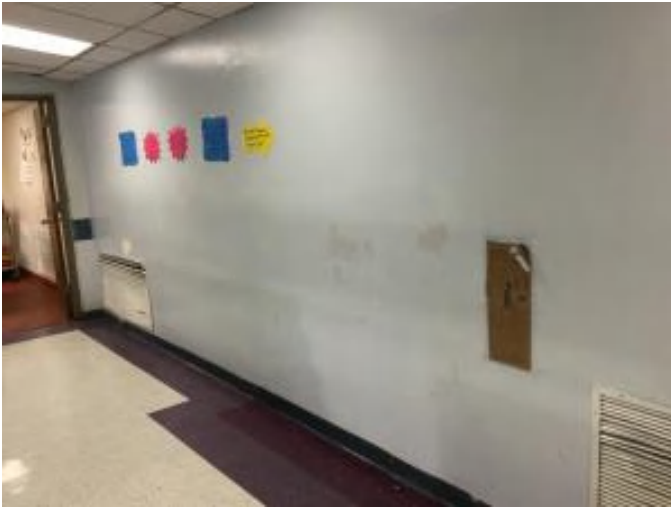
**System: C3010 - Wall Finishes**

**Location:** Interiors  
**Distress:** Beyond Service Life  
**Category:** Deferred Maintenance  
**Priority:** 3 - Necessary/Not Yet Critical (Years 2-5)  
**Correction:** Renew System  
**Qty:** 6,685.00  
**Unit of Measure:** S.F.  
**Estimate:** \$20,075.00  
**Assessor Name:** Somnath Das  
**Date Created:** 12/19/2016

**Notes:** Wall finishes are in need of renewal.

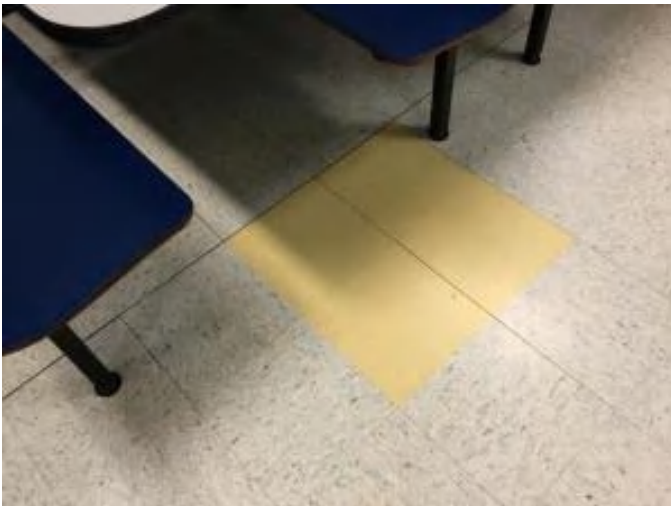
**System: C3020 - Floor Finishes**

**Location:** Throughout the building  
**Distress:** Beyond Service Life  
**Category:** Deferred Maintenance  
**Priority:** 3 - Necessary/Not Yet Critical (Years 2-5)  
**Correction:** Renew System  
**Qty:** 6,685.00  
**Unit of Measure:** S.F.  
**Estimate:** \$81,992.00  
**Assessor Name:** Somnath Das  
**Date Created:** 12/19/2016

**Notes:** Floor finishes are beyond their expected life throughout the building. Renewal is recommended.

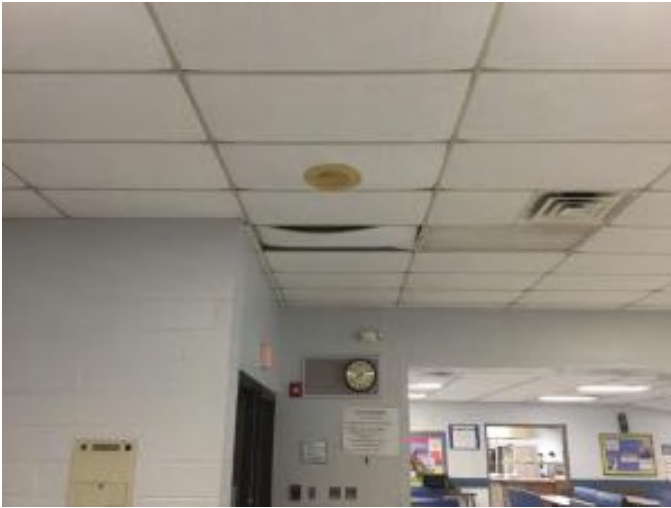
**System: C3030 - Ceiling Finishes**

**Location:** Throughout the building  
**Distress:** Beyond Service Life  
**Category:** Deferred Maintenance  
**Priority:** 3 - Necessary/Not Yet Critical (Years 2-5)  
**Correction:** Renew System  
**Qty:** 6,685.00  
**Unit of Measure:** S.F.  
**Estimate:** \$78,977.00  
**Assessor Name:** Somnath Das  
**Date Created:** 12/19/2016

**Notes:** Ceiling finishes are expired and in fair condition. Renewal is recommended.

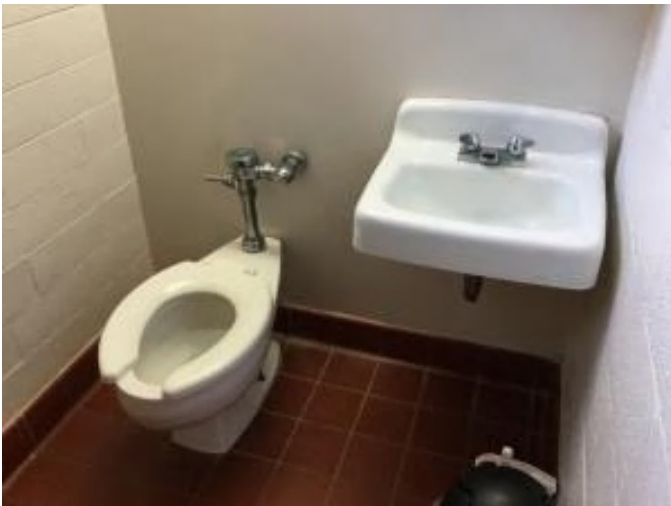
**System: D2010 - Plumbing Fixtures**

**Location:** Toilet room  
**Distress:** Beyond Service Life  
**Category:** Deferred Maintenance / Accessibility Code Compliance  
**Priority:** 3 - Necessary/Not Yet Critical (Years 2-5)  
**Correction:** Renew System  
**Qty:** 6,685.00  
**Unit of Measure:** S.F.  
**Estimate:** \$82,800.00  
**Assessor Name:** Somnath Das  
**Date Created:** 12/19/2016

**Notes:** Fixtures are beyond their expected life. Toilet room is not ADA compliant. System renewal is recommended.

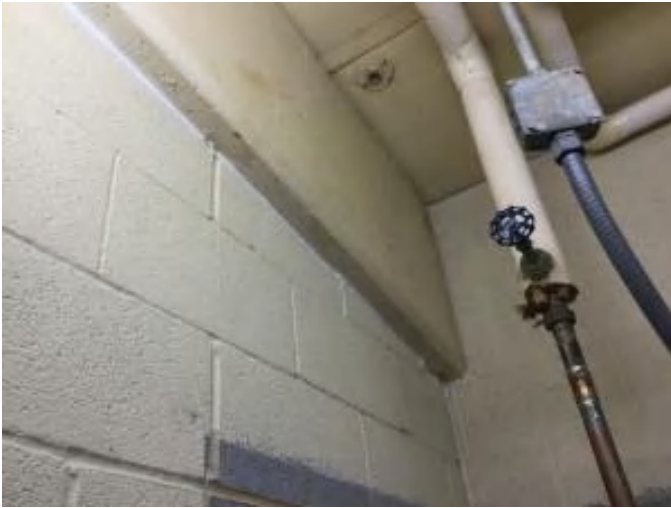
**System: D2020 - Domestic Water Distribution**

**Location:** Throughout the building  
**Distress:** Beyond Service Life  
**Category:** Deferred Maintenance  
**Priority:** 3 - Necessary/Not Yet Critical (Years 2-5)  
**Correction:** Renew System  
**Qty:** 6,685.00  
**Unit of Measure:** S.F.  
**Estimate:** \$7,059.00  
**Assessor Name:** Somnath Das  
**Date Created:** 12/19/2016

**Notes:** The domestic water system has exceeded its useful life. There is no backflow prevention on the water supply. system renewal is recommended.

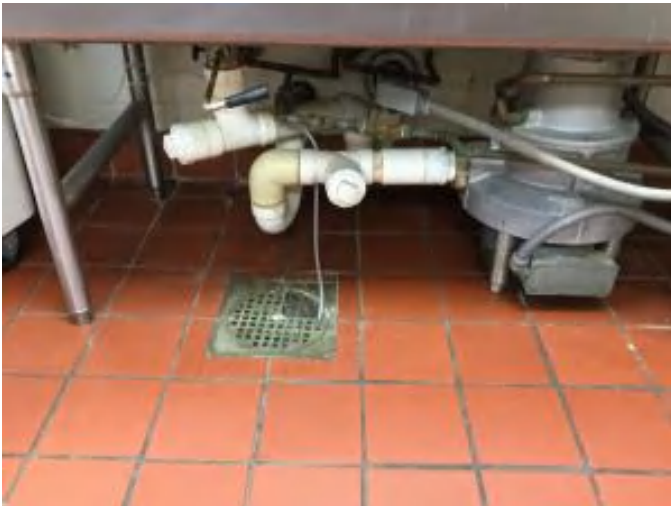
**System: D2030 - Sanitary Waste**

**Location:** Kitchen and support spaces  
**Distress:** Beyond Service Life  
**Category:** Deferred Maintenance  
**Priority:** 3 - Necessary/Not Yet Critical (Years 2-5)  
**Correction:** Renew System  
**Qty:** 6,685.00  
**Unit of Measure:** S.F.  
**Estimate:** \$11,177.00  
**Assessor Name:** Somnath Das  
**Date Created:** 12/19/2016

**Notes:** The sanitary sewer system has exceeded its expected useful life. System renewal is recommended.

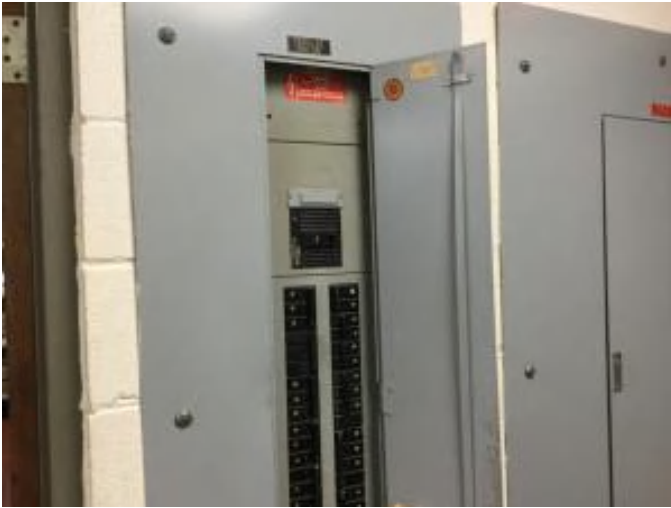
**System: D5020 - Branch Wiring**

**Location:** Throughout the building  
**Distress:** Beyond Service Life  
**Category:** Deferred Maintenance  
**Priority:** 3 - Necessary/Not Yet Critical (Years 2-5)  
**Correction:** Renew System  
**Qty:** 6,685.00  
**Unit of Measure:** S.F.  
**Estimate:** \$36,694.00  
**Assessor Name:** Somnath Das  
**Date Created:** 12/19/2016

**Notes:** The branch wiring system has exceeded its useful life. System renewal is recommended.

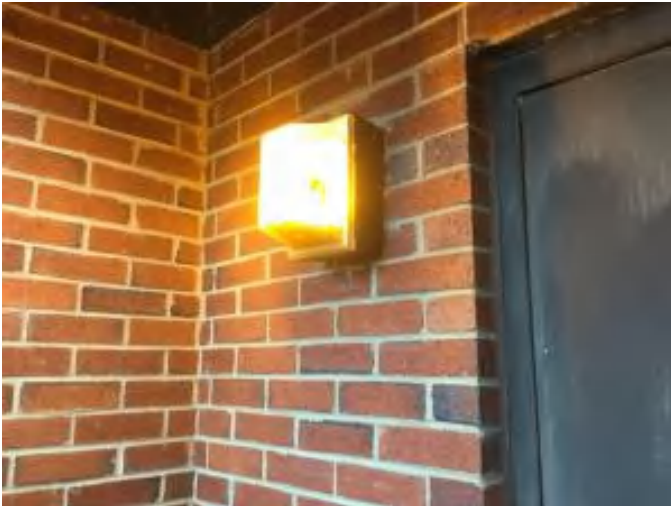
**System: D5020 - Lighting**

**Location:** Throughout the building  
**Distress:** Beyond Service Life  
**Category:** Deferred Maintenance  
**Priority:** 3 - Necessary/Not Yet Critical (Years 2-5)  
**Correction:** Renew System  
**Qty:** 6,685.00  
**Unit of Measure:** S.F.  
**Estimate:** \$85,595.00  
**Assessor Name:** Somnath Das  
**Date Created:** 12/19/2016

**Notes:** Lighting systems in the building are beyond their expected life and should be replaced.

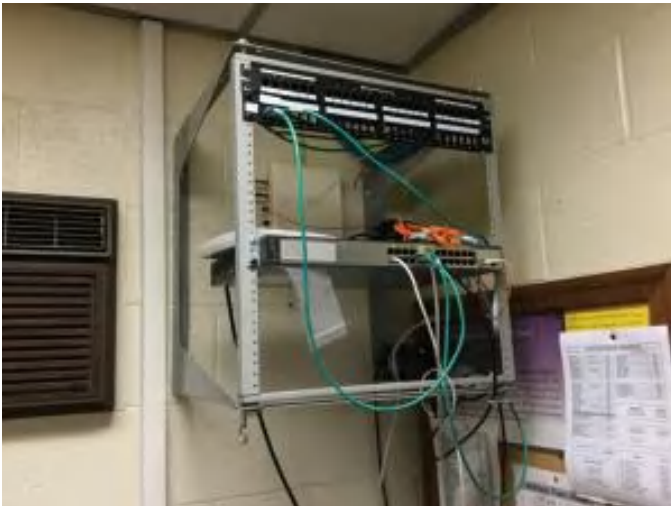
**System: D5030920 - Data Communication**

**Location:** Throughout the building  
**Distress:** Beyond Service Life  
**Category:** Deferred Maintenance  
**Priority:** 3 - Necessary/Not Yet Critical (Years 2-5)  
**Correction:** Renew System  
**Qty:** 6,685.00  
**Unit of Measure:** S.F.  
**Estimate:** \$31,620.00  
**Assessor Name:** Somnath Das  
**Date Created:** 12/19/2016

**Notes:** Data and communications systems are beyond their expected life. System renewal is recommended.

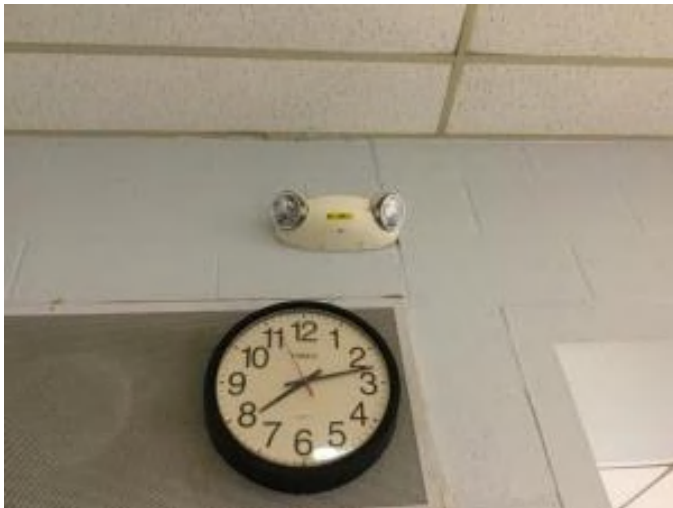
**System: D5090 - Other Electrical Systems**

**Location:** Throughout the building  
**Distress:** Beyond Service Life  
**Category:** Deferred Maintenance / Life Safety Code Compliance  
**Priority:** 3 - Necessary/Not Yet Critical (Years 2-5)  
**Correction:** Renew System  
**Qty:** 6,685.00  
**Unit of Measure:** S.F.  
**Estimate:** \$882.00  
**Assessor Name:** Somnath Das  
**Date Created:** 12/19/2016

**Notes:** Emergency lighting and illuminated exit signage is beyond its expected useful life. System renewal is recommended.

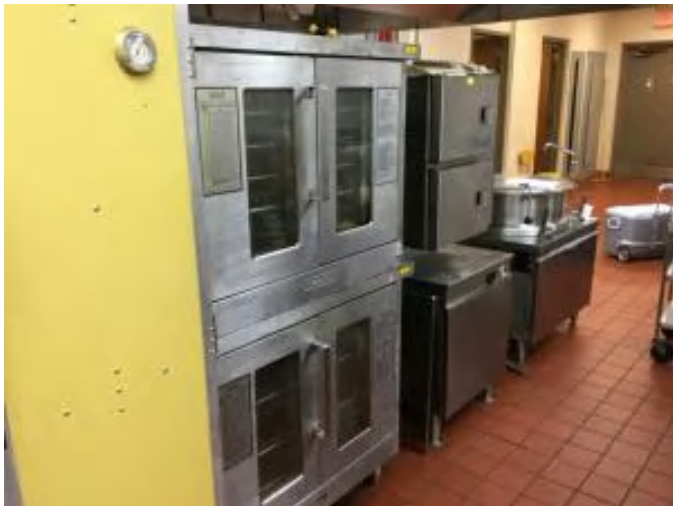
**System: E1090 - Other Equipment**

**Location:** Kitchen  
**Distress:** Beyond Service Life  
**Category:** Deferred Maintenance  
**Priority:** 3 - Necessary/Not Yet Critical (Years 2-5)  
**Correction:** Renew System  
**Qty:** 6,685.00  
**Unit of Measure:** S.F.  
**Estimate:** \$15,884.00  
**Assessor Name:** Somnath Das  
**Date Created:** 12/19/2016

**Notes:** Kitchen equipment is generally well beyond its expected useful life. System renewal is recommended.
