# Anson Middle

## Campus Assessment Report

March 7, 2017

## Campus Assessment Report - 1966 Building, Cafe/Gym

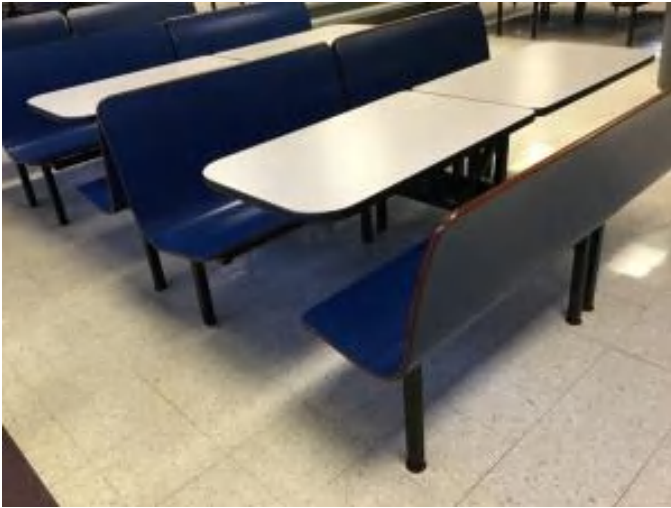
**System: E2010 - Fixed Furnishings**

**Location:** Dining room  
**Distress:** Beyond Service Life  
**Category:** Deferred Maintenance  
**Priority:** 4 - Recommended (Years 6-10)  
**Correction:** Renew System  
**Qty:** 6,685.00  
**Unit of Measure:** S.F.  
**Estimate:** \$42,062.00  
**Assessor Name:** Somnath Das  
**Date Created:** 12/19/2016

**Notes:** Fixed furnishing have exceeded their useful life. System renewal is recommended.

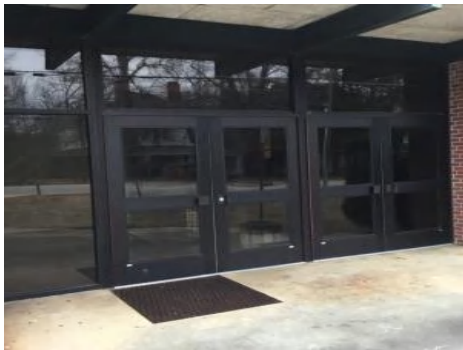
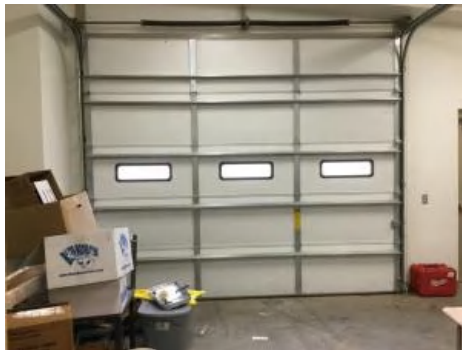
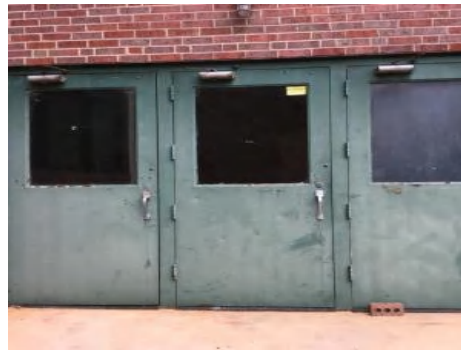
**System:** B2030 - Exterior Doors

**Note:** Front entrance doors replaced. Hardware on 6 rear doors replaced 2012.

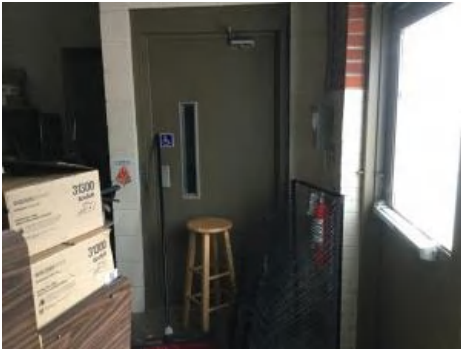
**System:** D1010 - Elevators and Lifts

**Note:** Elevator was locked and not in operation at time of visit.

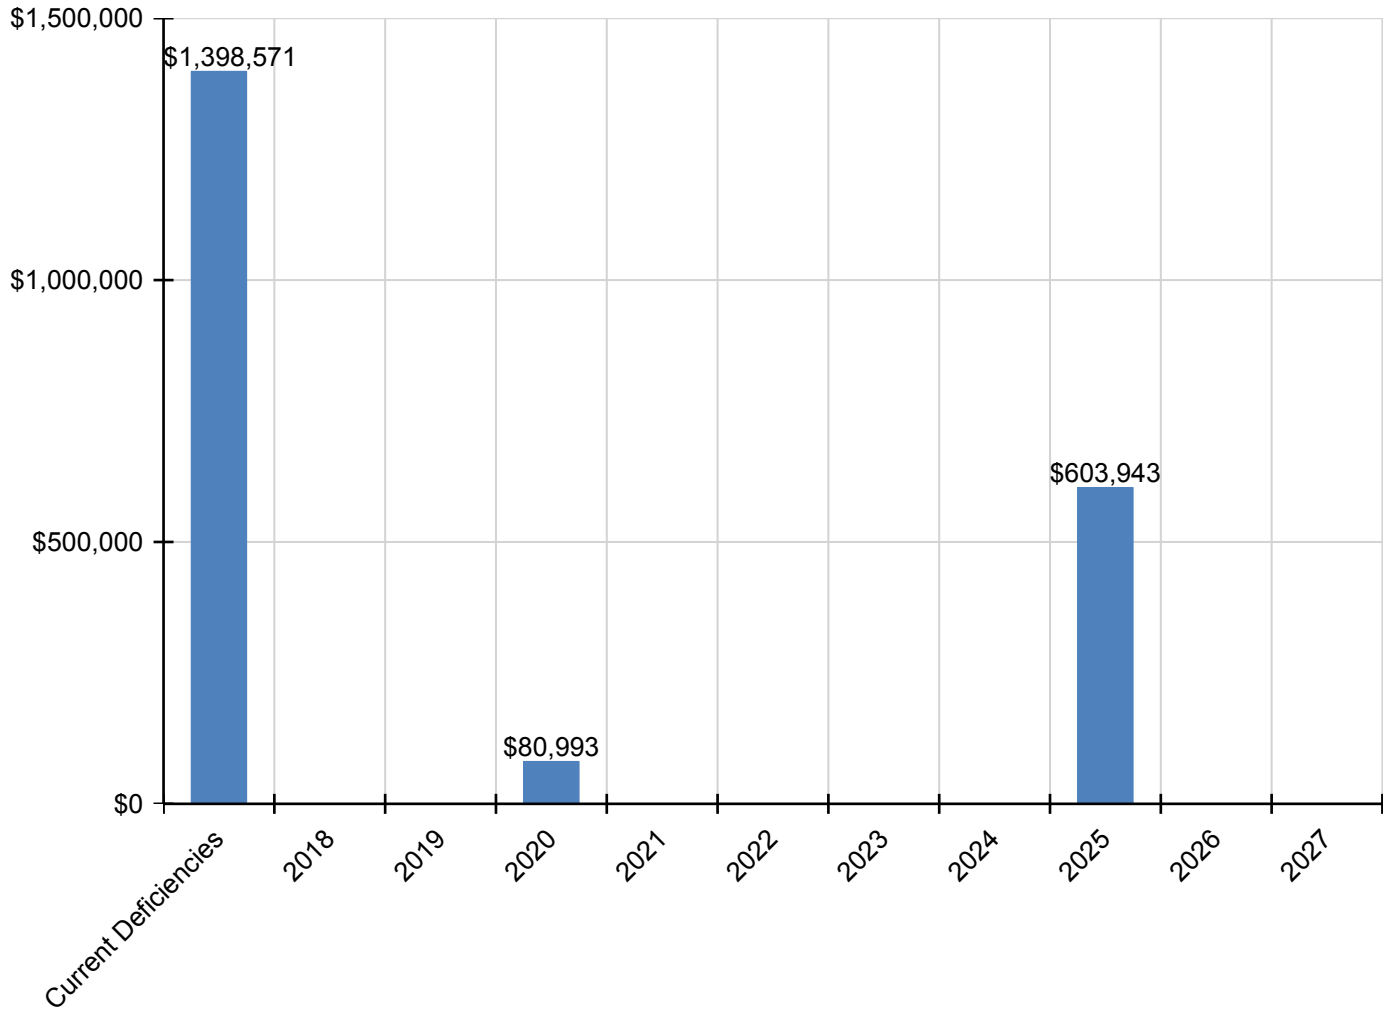
## Forecasted Capital Renewal Requirement

The following chart shows the current building deficiencies and forecasting capital renewal or sustainment requirements over the next ten years.

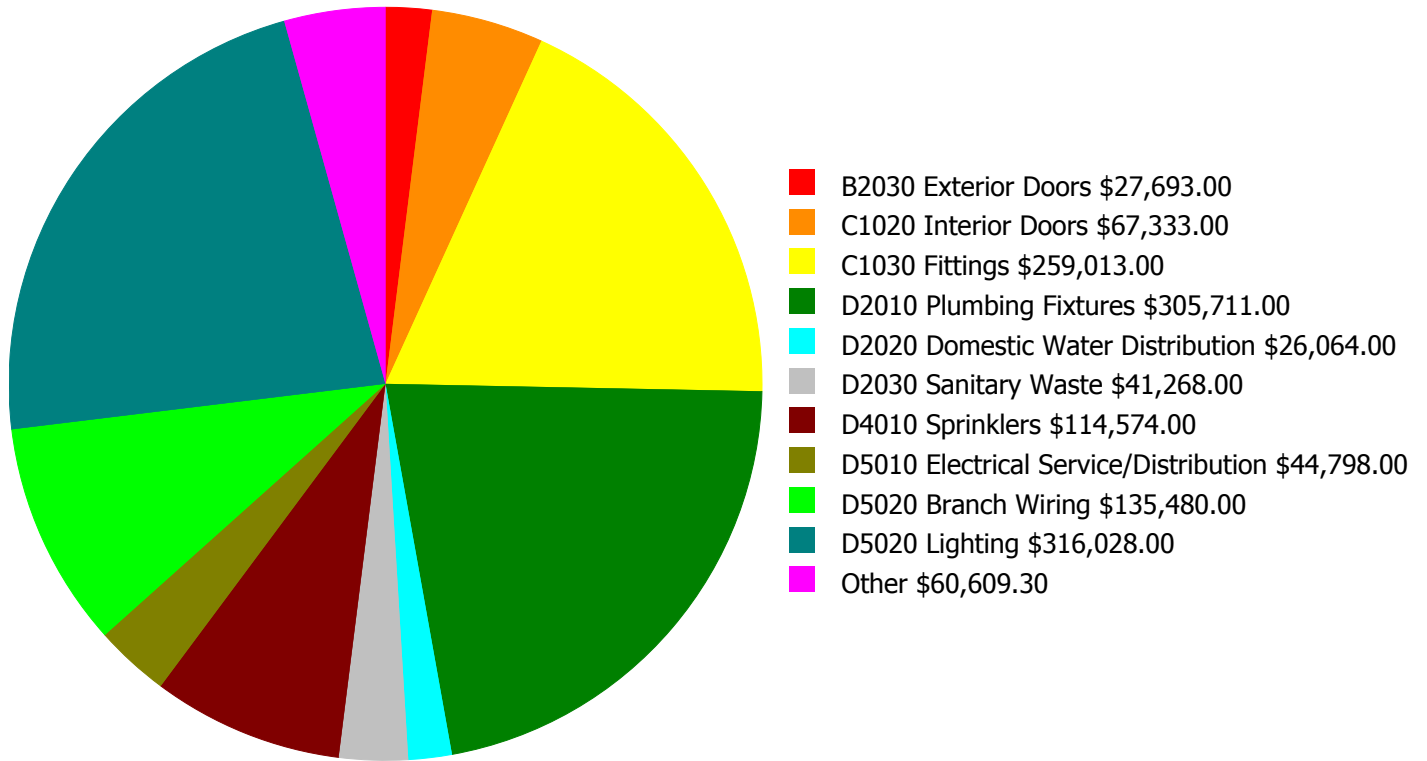
## Deficiency Summary by System

Current deficiencies included assemblies that have reached or exceeded their design life or components of the assemblies that are in need of repair. Assemblies that have reached their design life are identified as current deficiencies and assigned the distress 'Beyond Useful Life'. The following chart lists all current deficiencies associated with this facility.

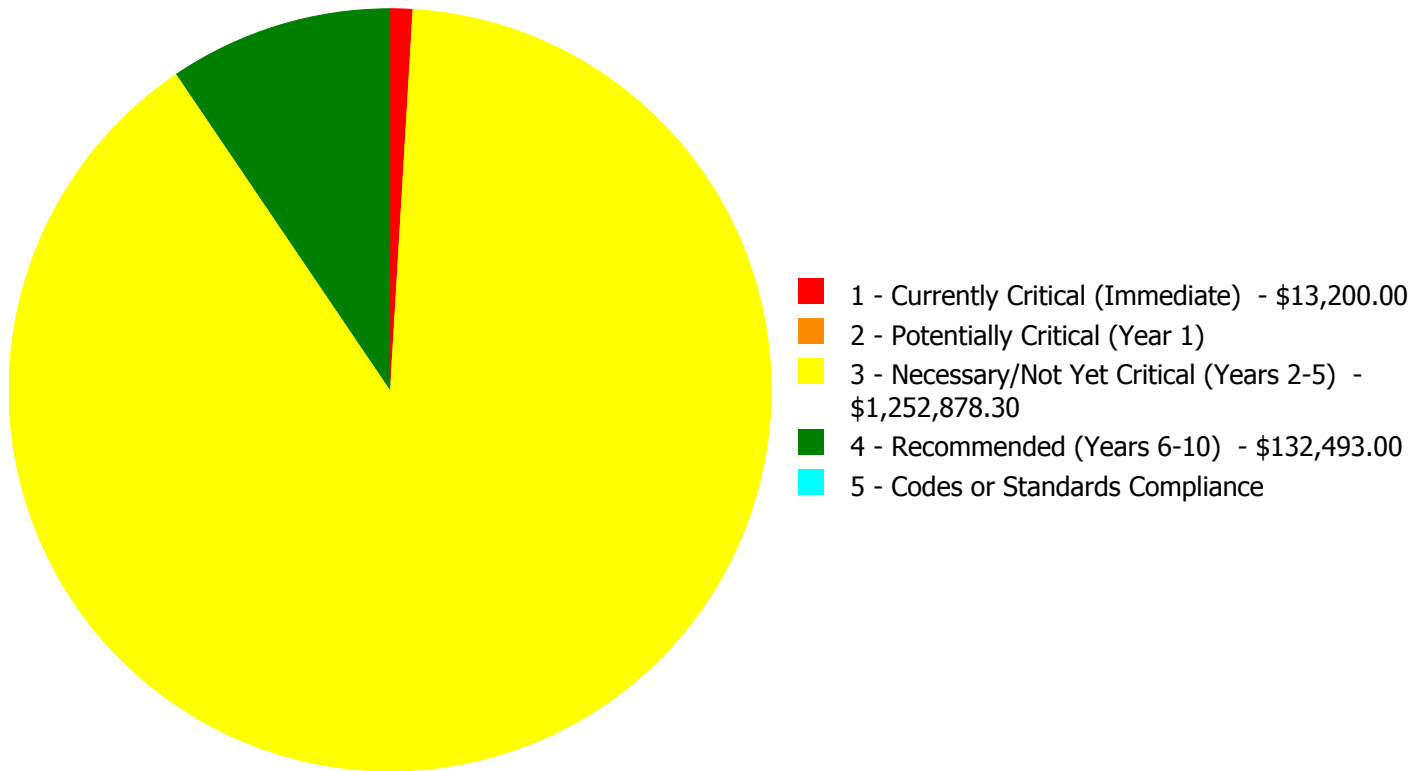
## Deficiency Summary by Priority

The following chart shows the total repair costs broken down by priority. Assessors assigned deficiencies within eCOMET to one of the following priority categories:

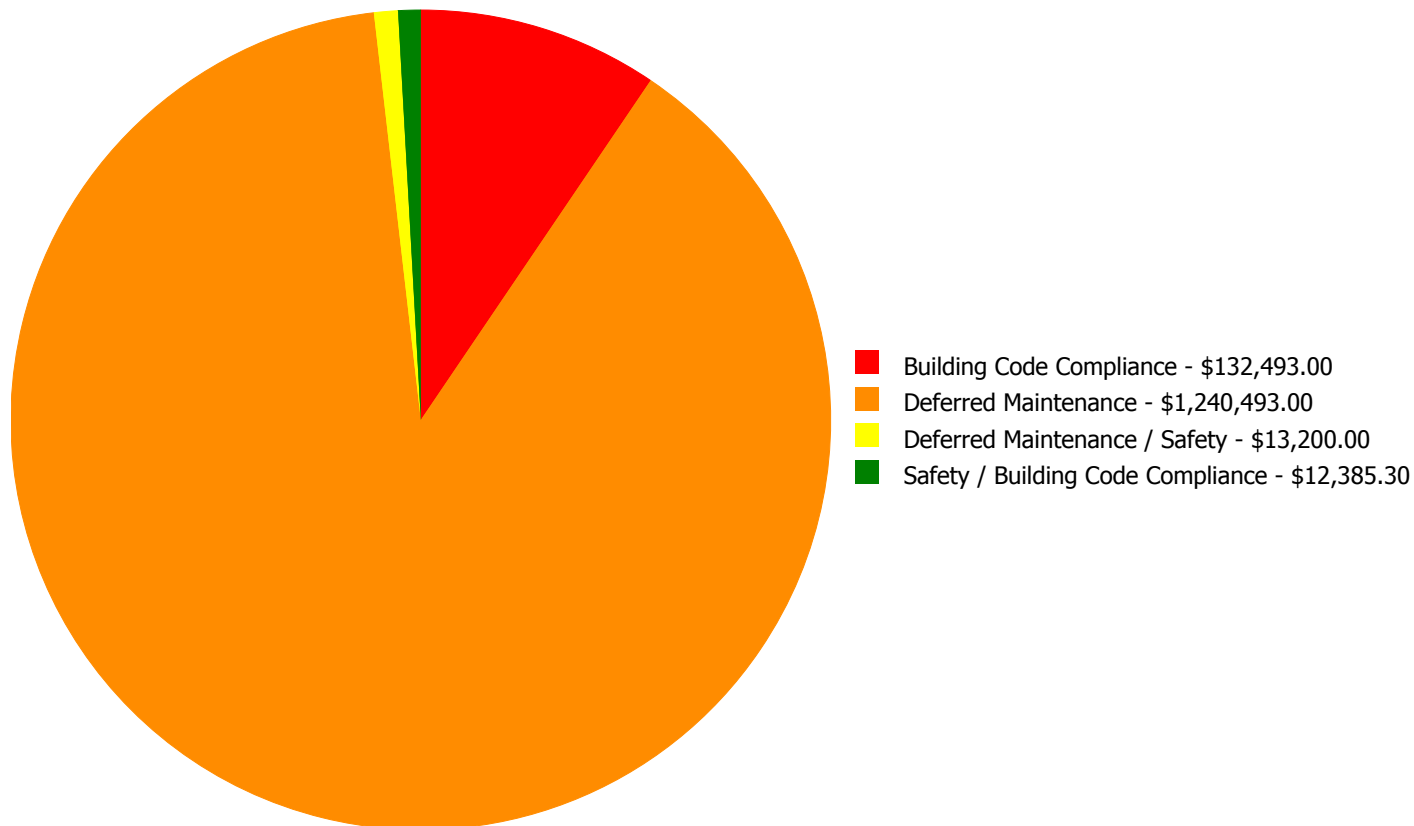
### Deficiency Summary by Category

The following chart shows the total repair costs broken down by deficiency categories. Assessors assigned deficiencies to one of the following categories:

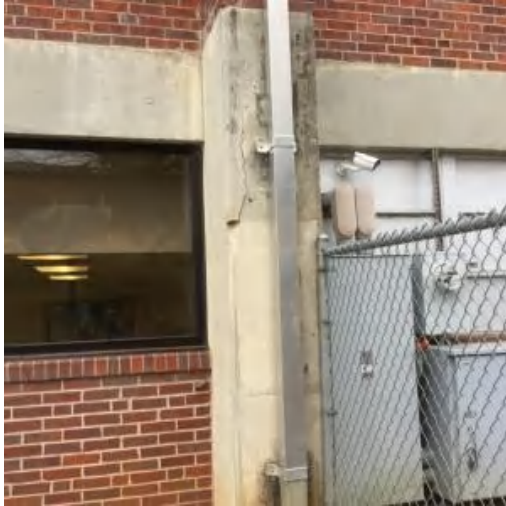
#### **System: B2010 - Exterior Walls**

**Location:** Exterior columns  
**Distress:** Damaged  
**Category:** Deferred Maintenance / Safety  
**Priority:** 1 - Currently Critical (Immediate)  
**Correction:** Engineering Study-2016-11-15 17:41:59  
**Qty:** 1.00  
**Unit of Measure:** Ea.  
**Estimate:** \$13,200.00  
**Assessor Name:** Somnath Das  
**Date Created:** 02/10/2017

**Notes:** Exposed exterior concrete columns and beams have some spalling of concrete and cracking. It appears that some repairs have already been made in some places. Evaluation by a structural engineer is recommended. The correction does not include the cost of repairs.

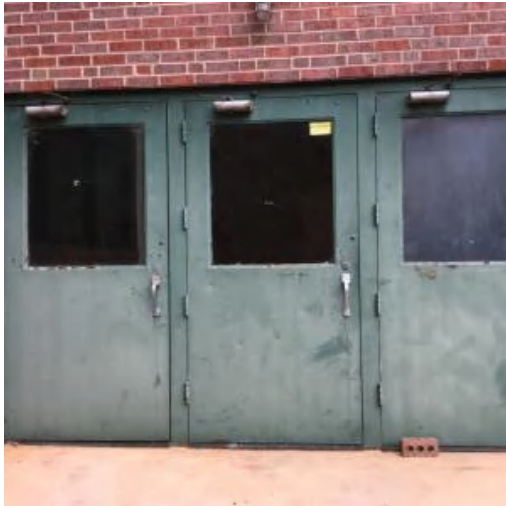
**System: B2030 - Exterior Doors**

**Location:** Exit doors.  
**Distress:** Beyond Service Life  
**Category:** Deferred Maintenance  
**Priority:** 3 - Necessary/Not Yet Critical (Years 2-5)  
**Correction:** Renew System  
**Qty:** 24,682.00  
**Unit of Measure:** S.F.  
**Estimate:** \$27,693.00  
**Assessor Name:** Somnath Das  
**Date Created:** 02/09/2017

**Notes:** Academy front door replaced circa 2010. Front entrance doors replaced 2012 Anson. Hardware only on 6 rear exit doors replaced 2012. Doors and frames are in very poor condition. Other miscellaneous exterior doors are in poor condition. System renewal is recommended.

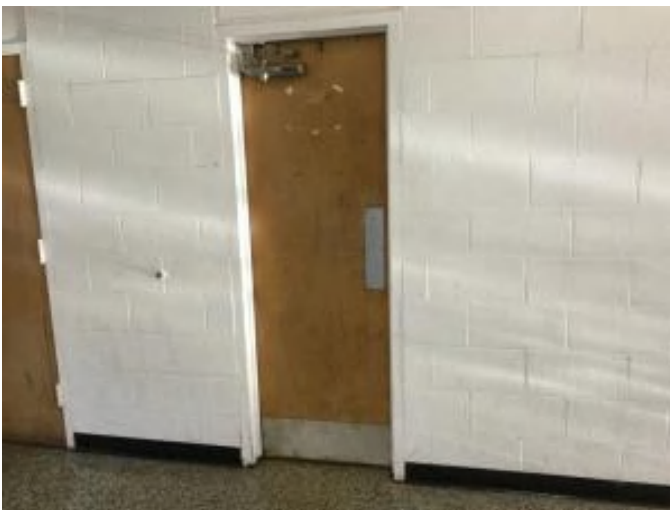
**System: C1020 - Interior Doors**

**Location:** Original portions of building  
**Distress:** Beyond Service Life  
**Category:** Deferred Maintenance  
**Priority:** 3 - Necessary/Not Yet Critical (Years 2-5)  
**Correction:** Renew System  
**Qty:** 24,682.00  
**Unit of Measure:** S.F.  
**Estimate:** \$67,333.00  
**Assessor Name:** Somnath Das  
**Date Created:** 12/20/2016

**Notes:** Interior doors are in fair to poor condition and should be replaced.

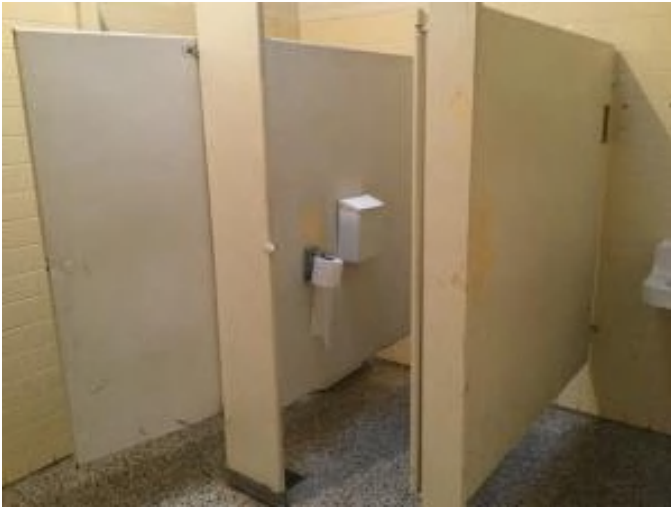
**System: C1030 - Fittings**

**Location:** Original portion of building  
**Distress:** Beyond Service Life  
**Category:** Deferred Maintenance  
**Priority:** 3 - Necessary/Not Yet Critical (Years 2-5)  
**Correction:** Renew System  
**Qty:** 24,682.00  
**Unit of Measure:** S.F.  
**Estimate:** \$259,013.00  
**Assessor Name:** Somnath Das  
**Date Created:** 12/20/2016

**Notes:** Original fittings are in poor condition and should be replaced. Signage on the upper level is inadequate.

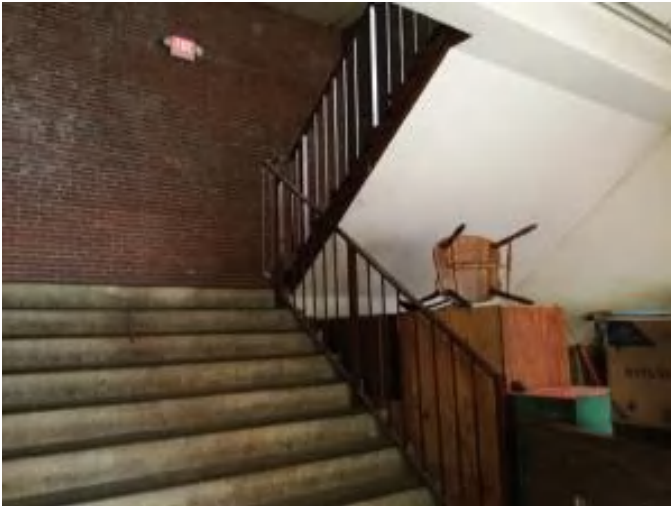
**System: C20 - Stairs**

**Location:** Southeast exit stairs  
**Distress:** Inadequate  
**Category:** Safety / Building Code Compliance  
**Priority:** 3 - Necessary/Not Yet Critical (Years 2-5)  
**Correction:** Replace Stair Rails  
**Qty:** 60.00  
**Unit of Measure:** L.F.  
**Estimate:** \$12,385.30  
**Assessor Name:** Somnath Das  
**Date Created:** 02/09/2017

**Notes:** Handrails at exit stairs are not up to code. Replacement is recommended.

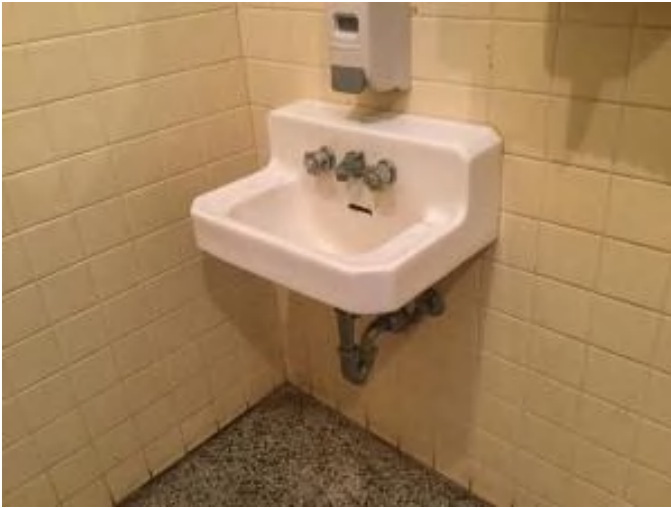
**System: D2010 - Plumbing Fixtures**

**Location:** Lobby restrooms and old restrooms  
**Distress:** Beyond Service Life  
**Category:** Deferred Maintenance  
**Priority:** 3 - Necessary/Not Yet Critical (Years 2-5)  
**Correction:** Renew System  
**Qty:** 24,682.00  
**Unit of Measure:** S.F.  
**Estimate:** \$305,711.00  
**Assessor Name:** Somnath Das  
**Date Created:** 12/20/2016

**Notes:** Plumbing fixtures were not replaced building-wide and are in poor condition. Renew the system.

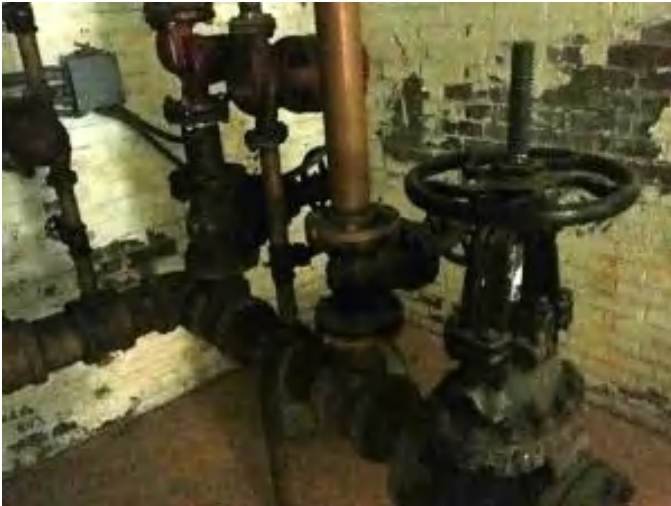
**System: D2020 - Domestic Water Distribution**

**Location:** Original portion of building  
**Distress:** Beyond Service Life  
**Category:** Deferred Maintenance  
**Priority:** 3 - Necessary/Not Yet Critical (Years 2-5)  
**Correction:** Renew System  
**Qty:** 24,682.00  
**Unit of Measure:** S.F.  
**Estimate:** \$26,064.00  
**Assessor Name:** Somnath Das  
**Date Created:** 12/20/2016

**Notes:** The original portion of the building not renovated for Anson Academy has expired water supply system. It should be replaced.

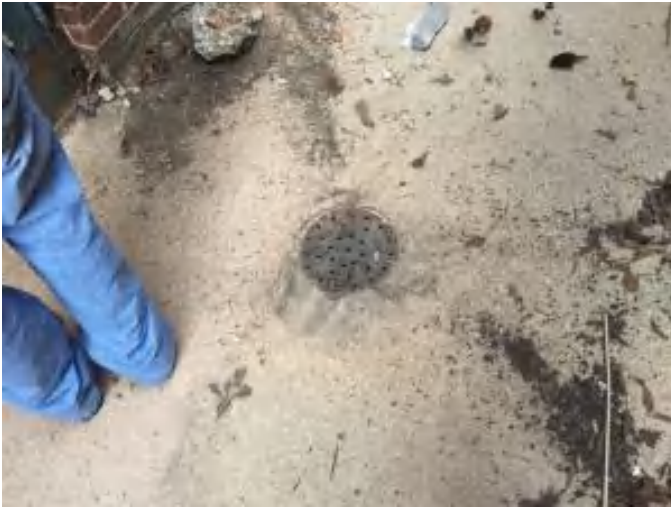
**System: D2030 - Sanitary Waste**

**Location:** Throughout the building  
**Distress:** Beyond Service Life  
**Category:** Deferred Maintenance  
**Priority:** 3 - Necessary/Not Yet Critical (Years 2-5)  
**Correction:** Renew System  
**Qty:** 24,682.00  
**Unit of Measure:** S.F.  
**Estimate:** \$41,268.00  
**Assessor Name:** Somnath Das  
**Date Created:** 12/20/2016

**Notes:** The sanitary waste system is original and should be replaced.

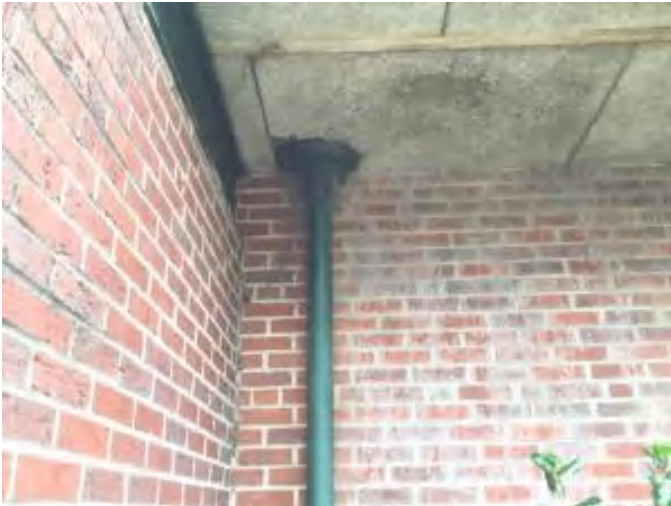
**System: D2040 - Rain Water Drainage**

**Location:** At front entry roof  
**Distress:** Beyond Service Life  
**Category:** Deferred Maintenance  
**Priority:** 3 - Necessary/Not Yet Critical (Years 2-5)  
**Correction:** Renew System  
**Qty:** 24,682.00  
**Unit of Measure:** S.F.  
**Estimate:** \$12,489.00  
**Assessor Name:** Somnath Das  
**Date Created:** 02/09/2017

**Notes:** Rainwater drainage system is presumed original, is beyond its expected life, and should be renewed.

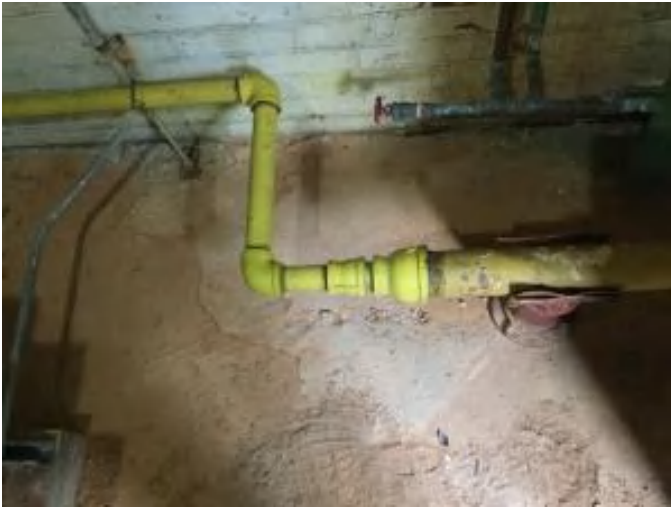
**System: D2090 - Other Plumbing Systems -Nat Gas**

**Location:** Boiler room  
**Distress:** Beyond Service Life  
**Category:** Deferred Maintenance  
**Priority:** 3 - Necessary/Not Yet Critical (Years 2-5)  
**Correction:** Renew System  
**Qty:** 24,682.00  
**Unit of Measure:** S.F.  
**Estimate:** \$4,616.00  
**Assessor Name:** Somnath Das  
**Date Created:** 12/20/2016

**Notes:** Gas piping is beyond its expected life and should be replaced.

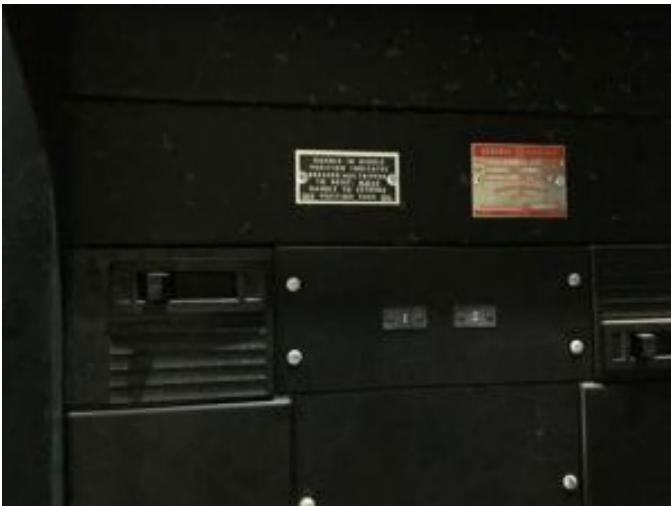
**System: D5010 - Electrical Service/Distribution**

**Location:** Electric service room  
**Distress:** Beyond Service Life  
**Category:** Deferred Maintenance  
**Priority:** 3 - Necessary/Not Yet Critical (Years 2-5)  
**Correction:** Renew System  
**Qty:** 24,682.00  
**Unit of Measure:** S.F.  
**Estimate:** \$44,798.00  
**Assessor Name:** Somnath Das  
**Date Created:** 12/20/2016

**Notes:** The original electric service is well beyond its expected life. It shares space with the boiler. System renewal is recommended.

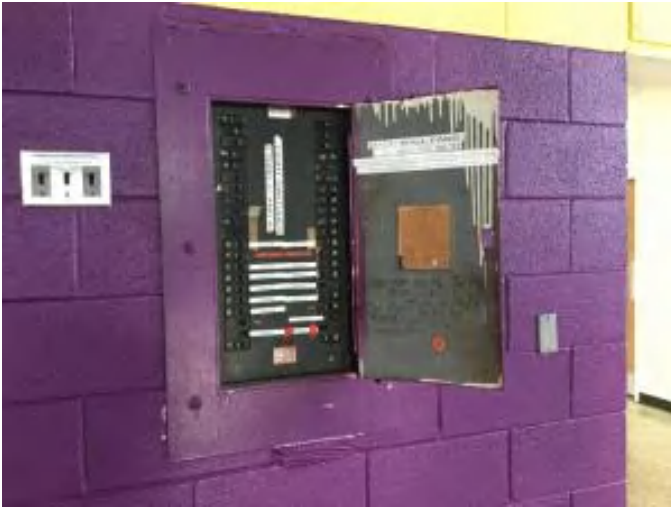
**System: D5020 - Branch Wiring**

**Location:** Throughout the building  
**Distress:** Beyond Service Life  
**Category:** Deferred Maintenance  
**Priority:** 3 - Necessary/Not Yet Critical (Years 2-5)  
**Correction:** Renew System  
**Qty:** 24,682.00  
**Unit of Measure:** S.F.  
**Estimate:** \$135,480.00  
**Assessor Name:** Somnath Das  
**Date Created:** 12/20/2016

**Notes:** With the exception of Anson Academy, branch wiring is typically original and in need of replacement.

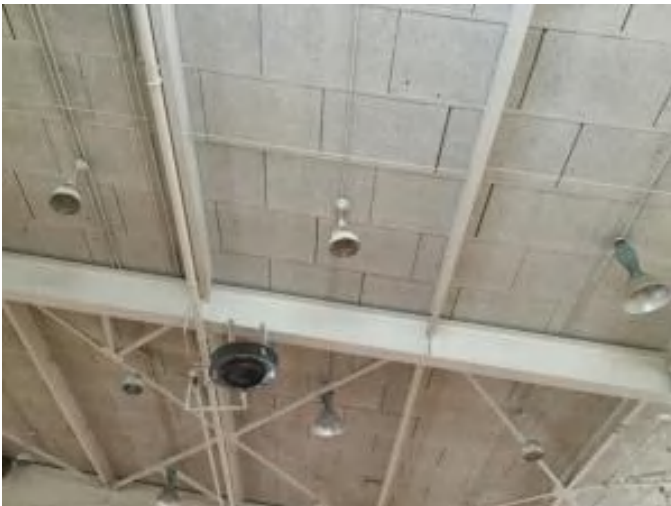
**System: D5020 - Lighting**

**Location:** Upper level and lower level ancillary spaces  
**Distress:** Beyond Service Life  
**Category:** Deferred Maintenance  
**Priority:** 3 - Necessary/Not Yet Critical (Years 2-5)  
**Correction:** Renew System  
**Qty:** 24,682.00  
**Unit of Measure:** S.F.  
**Estimate:** \$316,028.00  
**Assessor Name:** Somnath Das  
**Date Created:** 12/20/2016

**Notes:** With the exception of Anson Academy, lighting is old and in poor condition. System renewal is recommended.

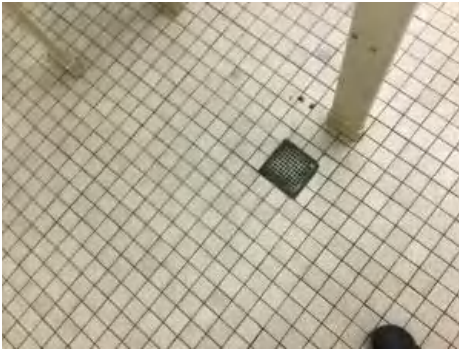
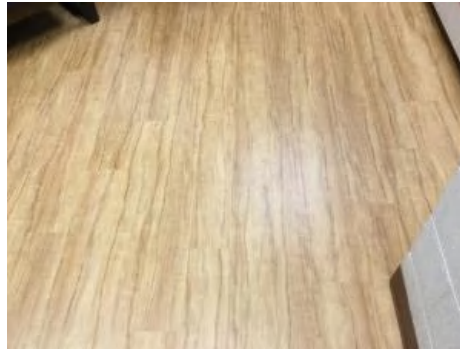
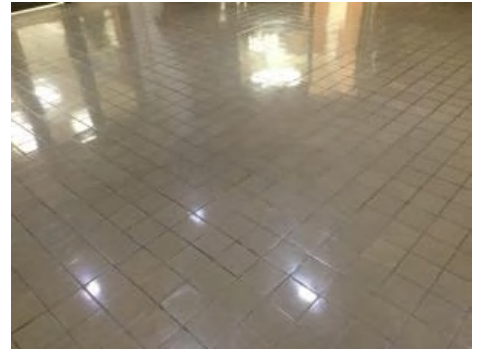
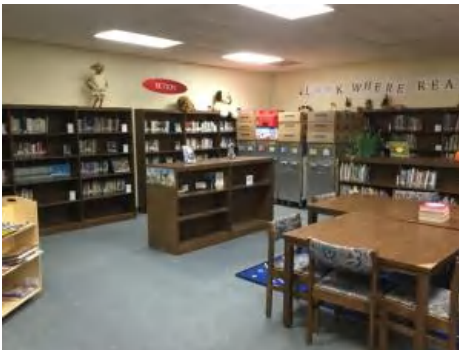
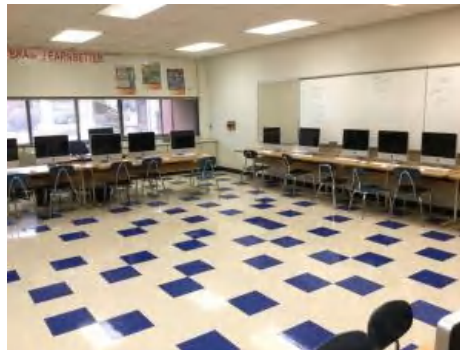
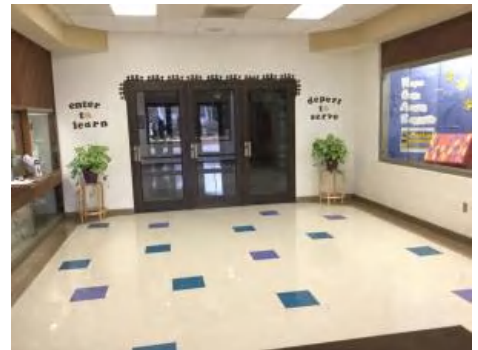
**System:** C3020 - Floor Finishes

**Note:** Ongoing project to replace floor tile in corridors and carpet with floor tile in classrooms.

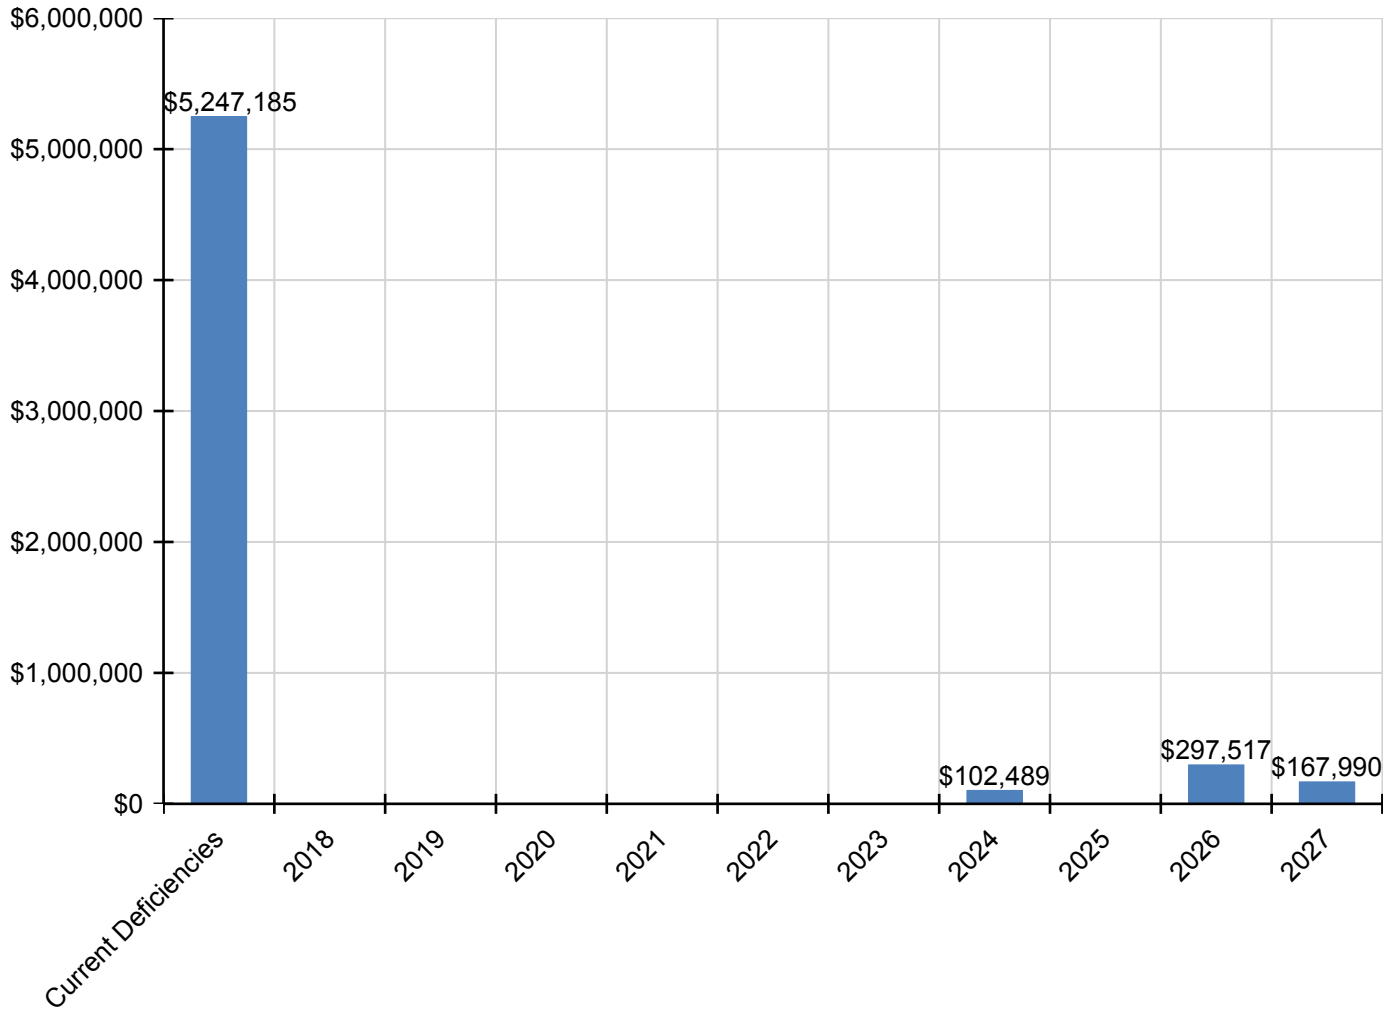
## Forecasted Capital Renewal Requirement

The following chart shows the current building deficiencies and forecasting capital renewal or sustainment requirements over the next ten years.

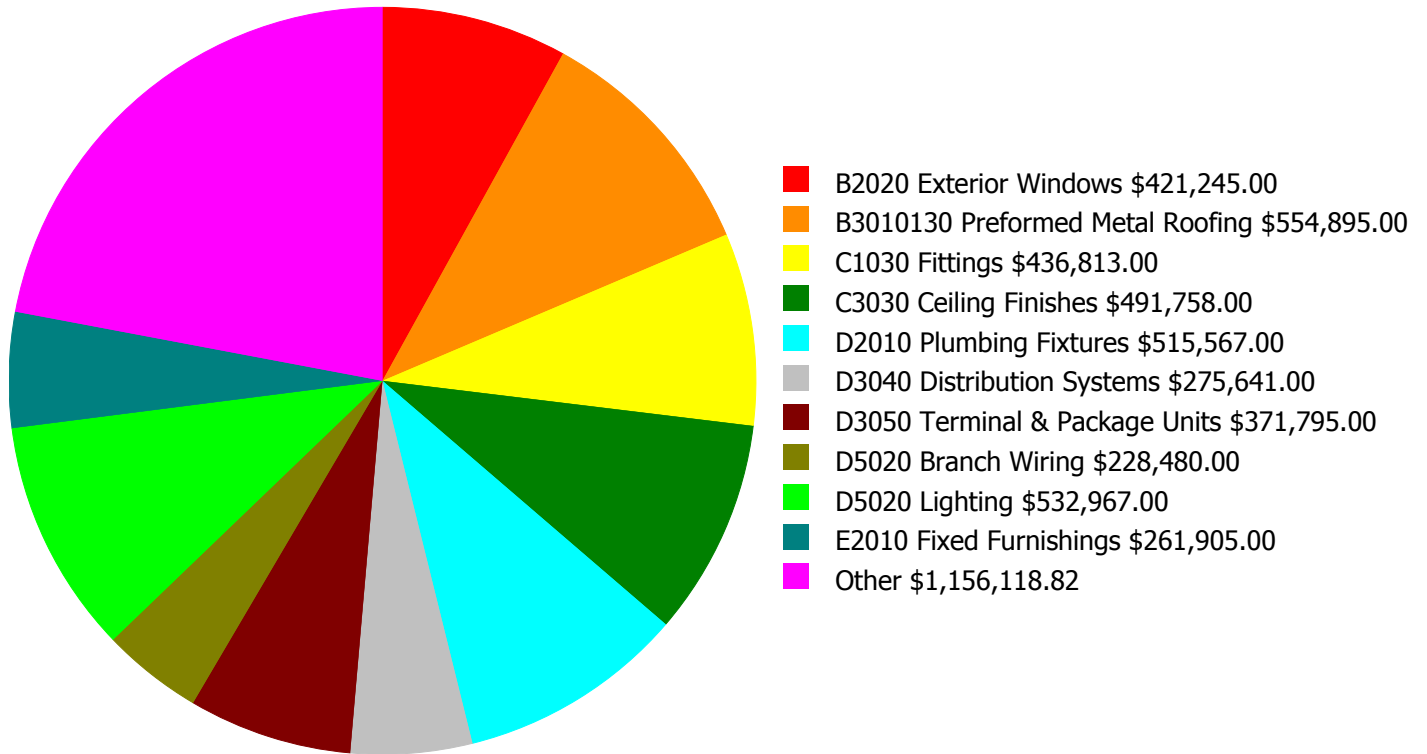
## Deficiency Summary by System

Current deficiencies included assemblies that have reached or exceeded their design life or components of the assemblies that are in need of repair. Assemblies that have reached their design life are identified as current deficiencies and assigned the distress 'Beyond Useful Life'. The following chart lists all current deficiencies associated with this facility.

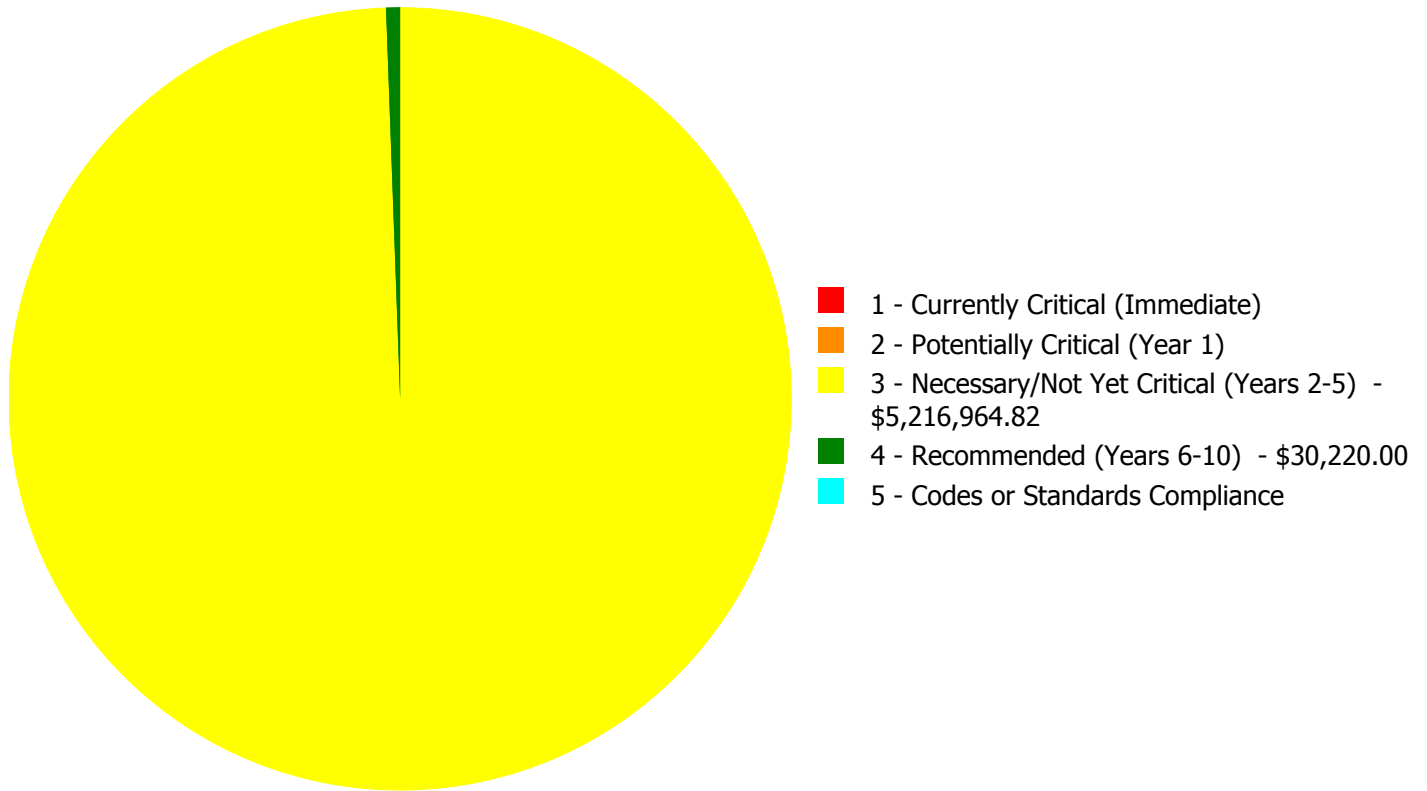
## Deficiency Summary by Priority

The following chart shows the total repair costs broken down by priority. Assessors assigned deficiencies within eCOMET to one of the following priority categories:

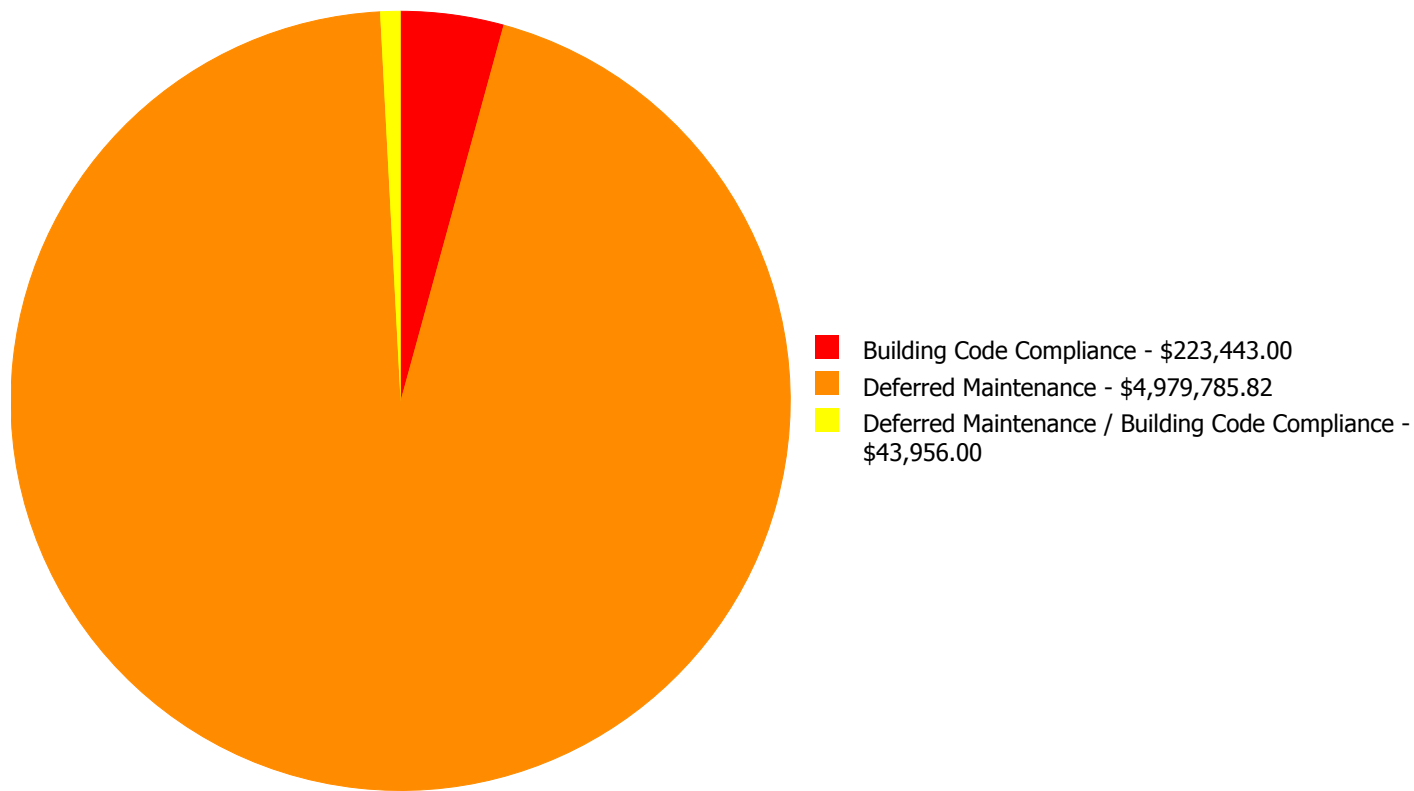
## Deficiency Summary by Category

The following chart shows the total repair costs broken down by deficiency categories. Assessors assigned deficiencies to one of the following categories:

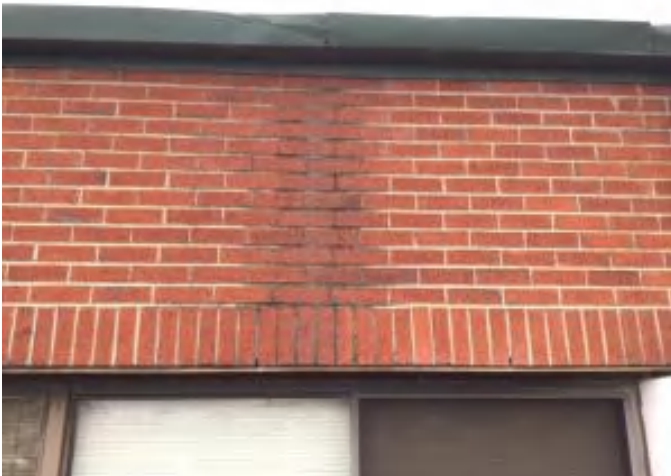
#### System: B2010 - Exterior Walls

**Location:** Exterior walls  
**Distress:** Damaged  
**Category:** Deferred Maintenance  
**Priority:** 3 - Necessary/Not Yet Critical (Years 2-5)  
**Correction:** Point clay brick wall, 1st floor  
**Qty:** 80.00  
**Unit of Measure:** C.S.F.  
**Estimate:** \$120,172.80  
**Assessor Name:** Eduardo Lopez  
**Date Created:** 02/10/2017

**Notes:** Exterior walls need to be maintained with pointing where there is loss of mortar and repair of cracked brick at areas of minor settlement.

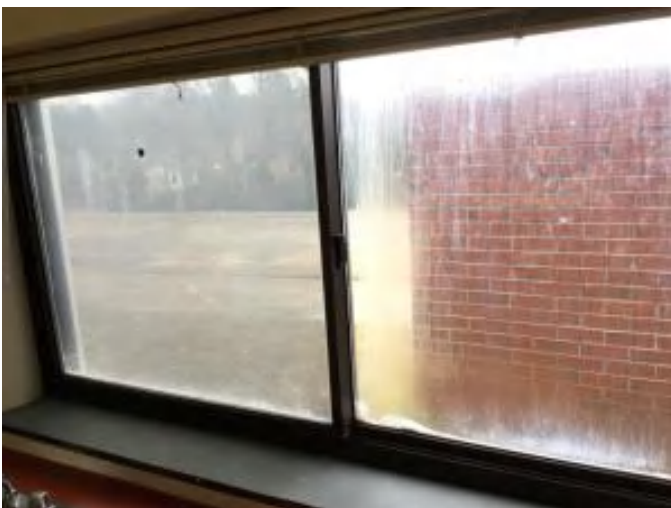
#### System: B2020 - Exterior Windows

**Location:** Exterior windows throughout  
**Distress:** Beyond Service Life  
**Category:** Deferred Maintenance  
**Priority:** 3 - Necessary/Not Yet Critical (Years 2-5)  
**Correction:** Renew System  
**Qty:** 41,625.00  
**Unit of Measure:** S.F.  
**Estimate:** \$421,245.00  
**Assessor Name:** Eduardo Lopez  
**Date Created:** 12/19/2016

**Notes:** Exterior windows are beyond their expected life and in poor condition with many lost seals and degradation of frame finishes. System replacement is recommended.

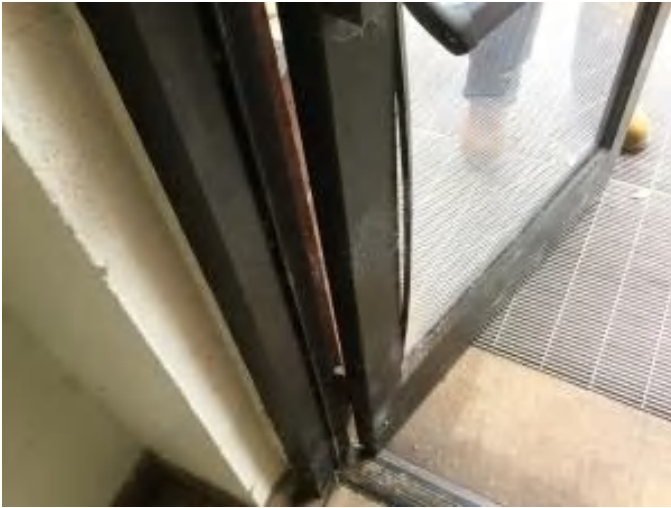
**System: B2030 - Exterior Doors**

**Location:** Exterior doors  
**Distress:** Beyond Service Life  
**Category:** Deferred Maintenance  
**Priority:** 3 - Necessary/Not Yet Critical (Years 2-5)  
**Correction:** Renew System  
**Qty:** 41,625.00  
**Unit of Measure:** S.F.  
**Estimate:** \$46,703.00  
**Assessor Name:** Eduardo Lopez  
**Date Created:** 12/19/2016

**Notes:** Exterior doors are beyond their expected life. System renewal is recommended.

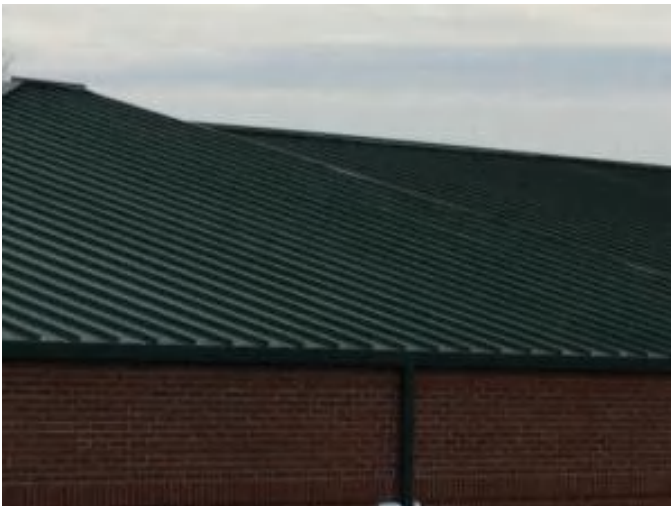
**System: B3010130 - Preformed Metal Roofing**

**Location:** Roof  
**Distress:** Beyond Service Life  
**Category:** Deferred Maintenance  
**Priority:** 3 - Necessary/Not Yet Critical (Years 2-5)  
**Correction:** Renew System  
**Qty:** 41,625.00  
**Unit of Measure:** S.F.  
**Estimate:** \$554,895.00  
**Assessor Name:** Eduardo Lopez  
**Date Created:** 12/19/2016

**Notes:** The roof is beyond its expected life and beginning to fail with leaks occurring around the building. Gutters and downspouts are in poor condition causing staining on the building. There are no snow/ice guards. Roof replacement is recommended.

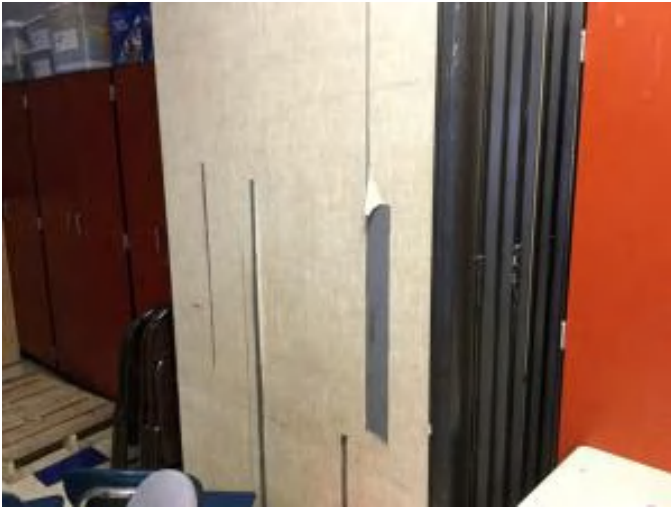
**System: C1010 - Partitions**

**Location:** Three Classrooms  
**Distress:** Beyond Service Life  
**Category:** Deferred Maintenance  
**Priority:** 3 - Necessary/Not Yet Critical (Years 2-5)  
**Correction:** Remove and reinstall demountable partitions  
**Qty:** 3.00  
**Unit of Measure:** C.L.F.  
**Estimate:** \$26,332.02  
**Assessor Name:** Eduardo Lopez  
**Date Created:** 02/11/2017

**Notes:** Folding partitions between classrooms are in poor condition and do not operate smoothly. Replacement is recommended.

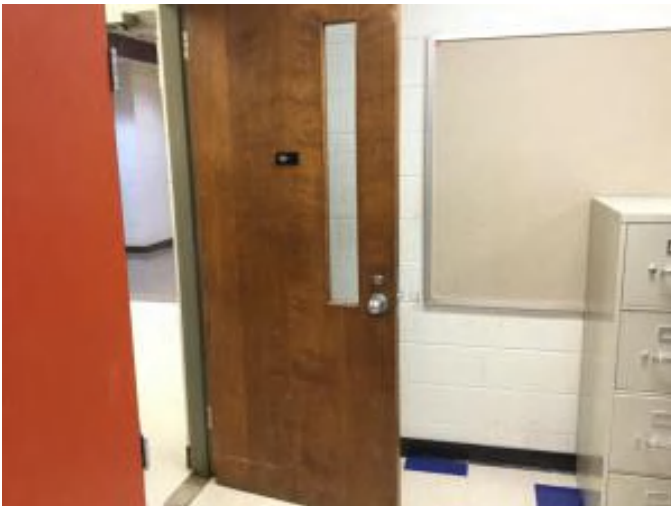
**System: C1020 - Interior Doors**

**Location:** Throughout the building  
**Distress:** Beyond Service Life  
**Category:** Deferred Maintenance  
**Priority:** 3 - Necessary/Not Yet Critical (Years 2-5)  
**Correction:** Renew System  
**Qty:** 41,625.00  
**Unit of Measure:** S.F.  
**Estimate:** \$113,553.00  
**Assessor Name:** Eduardo Lopez  
**Date Created:** 12/19/2016

**Notes:** Interior doors are original and beyond their expected life with worn finishes. There is no lever hardware. Some damaged trim around glazing observed. System renewal is recommended.

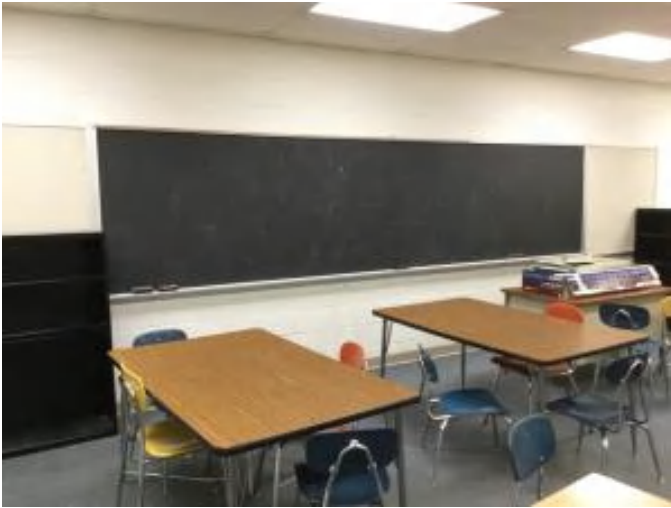
**System: C1030 - Fittings**

**Location:** Throughout the building  
**Distress:** Beyond Service Life  
**Category:** Deferred Maintenance  
**Priority:** 3 - Necessary/Not Yet Critical (Years 2-5)  
**Correction:** Renew System  
**Qty:** 41,625.00  
**Unit of Measure:** S.F.  
**Estimate:** \$436,813.00  
**Assessor Name:** Eduardo Lopez  
**Date Created:** 12/19/2016

**Notes:** Fittings in general are beyond their service life. Some blackboards are still present. Whiteboards are stained beyond cleaning. Interior signage is not code compliant. System renewal is recommended.

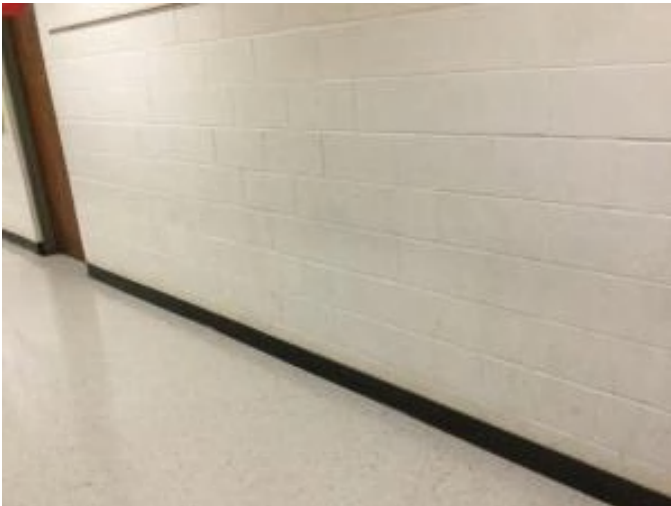
**System: C3010 - Wall Finishes**

**Location:** Throughout the building  
**Distress:** Beyond Service Life  
**Category:** Deferred Maintenance  
**Priority:** 3 - Necessary/Not Yet Critical (Years 2-5)  
**Correction:** Renew System  
**Qty:** 41,625.00  
**Unit of Measure:** S.F.  
**Estimate:** \$125,000.00  
**Assessor Name:** Eduardo Lopez  
**Date Created:** 12/19/2016

**Notes:** Wall finishes are in need of renewal.

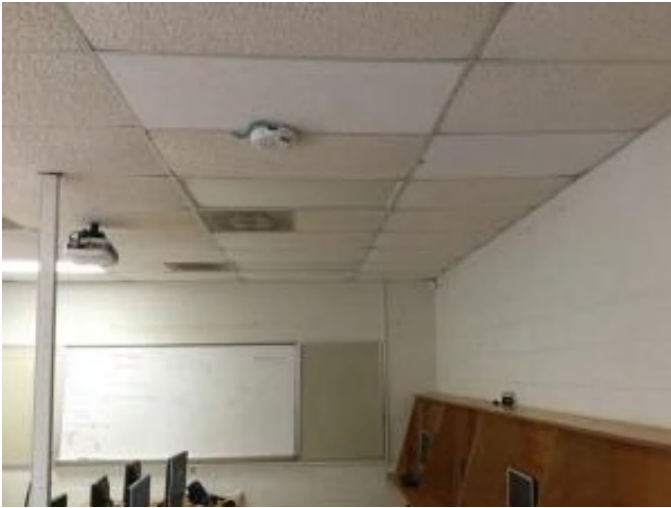
**System: C3030 - Ceiling Finishes**

**Location:** Throughout the building  
**Distress:** Beyond Service Life  
**Category:** Deferred Maintenance  
**Priority:** 3 - Necessary/Not Yet Critical (Years 2-5)  
**Correction:** Renew System  
**Qty:** 41,625.00  
**Unit of Measure:** S.F.  
**Estimate:** \$491,758.00  
**Assessor Name:** Eduardo Lopez  
**Date Created:** 12/19/2016

**Notes:** Ceilings are beyond their expected useful life. Numerous tiles are stained due to roof leaks. Tiles are mis-matched due to replacements over the years. System renewal is recommended.
