# Anson Middle

## Campus Assessment Report

March 7, 2017

## Campus Assessment Report - 1966 Building, Cafe/Gym

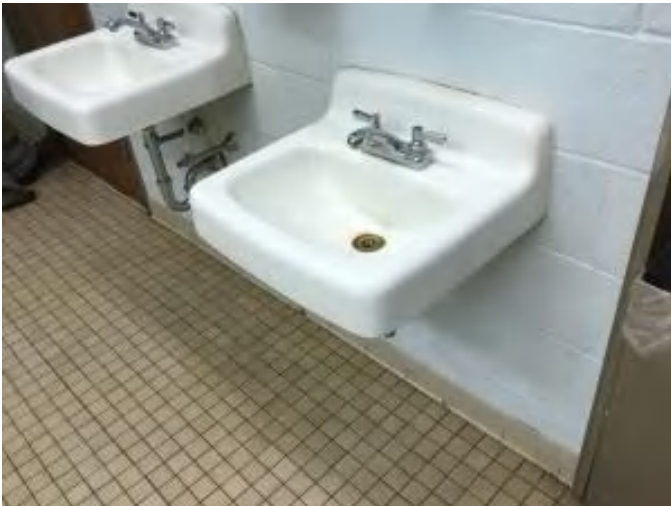
**System: D2010 - Plumbing Fixtures**

**Location:** Throughout the building  
**Distress:** Beyond Service Life  
**Category:** Deferred Maintenance  
**Priority:** 3 - Necessary/Not Yet Critical (Years 2-5)  
**Correction:** Renew System  
**Qty:** 41,625.00  
**Unit of Measure:** S.F.  
**Estimate:** \$515,567.00  
**Assessor Name:** Eduardo Lopez  
**Date Created:** 12/19/2016

**Notes:** Plumbing fixtures are beyond their expected life. Classroom sinks are in poor condition. Most fixtures are not low-flow type. Fixtures and toilet room configurations are not ADA compliant.

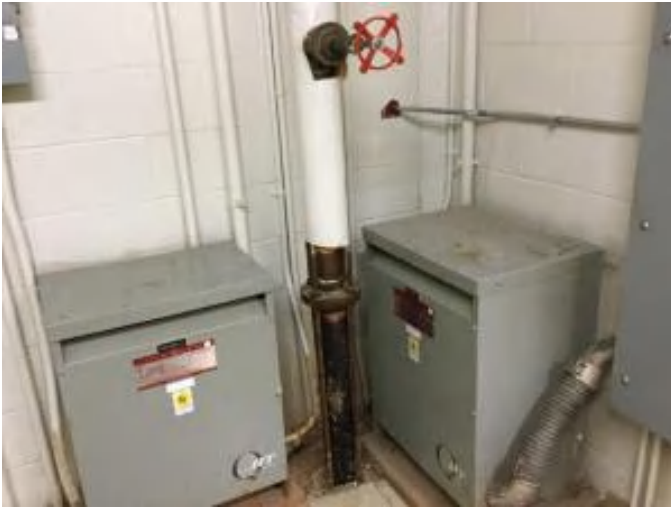
**System: D2020 - Domestic Water Distribution**

**Location:** Throughout the building  
**Distress:** Beyond Service Life  
**Category:** Deferred Maintenance / Building Code Compliance  
**Priority:** 3 - Necessary/Not Yet Critical (Years 2-5)  
**Correction:** Renew System  
**Qty:** 41,625.00  
**Unit of Measure:** S.F.  
**Estimate:** \$43,956.00  
**Assessor Name:** Eduardo Lopez  
**Date Created:** 12/19/2016

**Notes:** The water distribution system is expired. The service entrance does not have a backflow preventer. Water and electrical gear share the same space. System renewal is recommended.

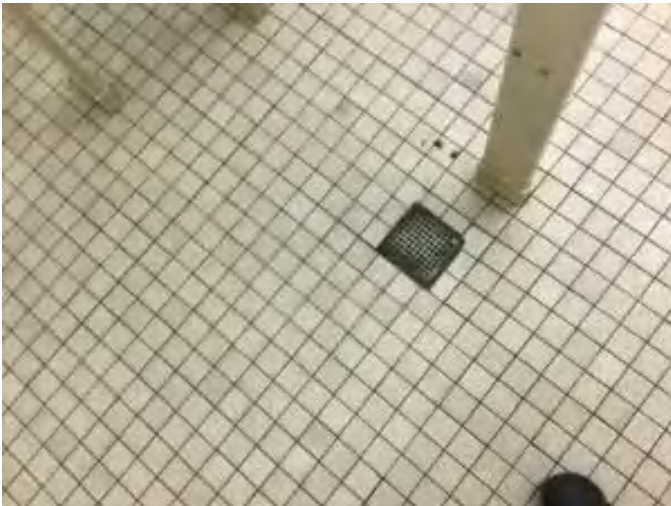
**System: D2030 - Sanitary Waste**

**Location:** Throughout the building  
**Distress:** Beyond Service Life  
**Category:** Deferred Maintenance  
**Priority:** 3 - Necessary/Not Yet Critical (Years 2-5)  
**Correction:** Renew System  
**Qty:** 41,625.00  
**Unit of Measure:** S.F.  
**Estimate:** \$69,597.00  
**Assessor Name:** Eduardo Lopez  
**Date Created:** 12/19/2016

**Notes:** The sanitary waste system has exceeded its expected useful life. System renewal is recommended.

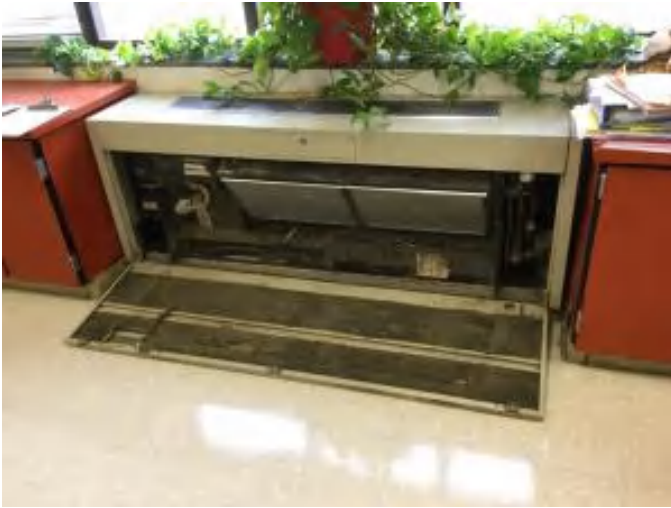
**System: D3040 - Distribution Systems**

**Location:** Throughout the building  
**Distress:** Beyond Service Life  
**Category:** Deferred Maintenance  
**Priority:** 3 - Necessary/Not Yet Critical (Years 2-5)  
**Correction:** Renew System  
**Qty:** 41,625.00  
**Unit of Measure:** S.F.  
**Estimate:** \$275,641.00  
**Assessor Name:** Eduardo Lopez  
**Date Created:** 12/19/2016

**Notes:** Distribution systems throughout the building are beyond their expected life. Unit ventilators in classrooms are worn out and parts are difficult to obtain. Ductwork has internal insulation. System renewal is recommended.

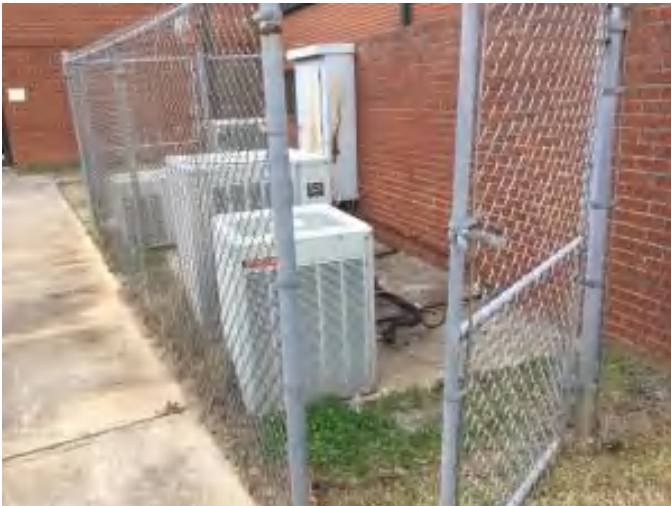
**System: D3050 - Terminal & Package Units**

**Location:** Throughout the building  
**Distress:** Beyond Service Life  
**Category:** Deferred Maintenance  
**Priority:** 3 - Necessary/Not Yet Critical (Years 2-5)  
**Correction:** Renew System  
**Qty:** 41,625.00  
**Unit of Measure:** S.F.  
**Estimate:** \$371,795.00  
**Assessor Name:** Eduardo Lopez  
**Date Created:** 12/19/2016

**Notes:** Ground mount condenser units are typically expired. Some units have been replaced as needed. There is insufficient cooling to data equipment rooms. System renewal is recommended.

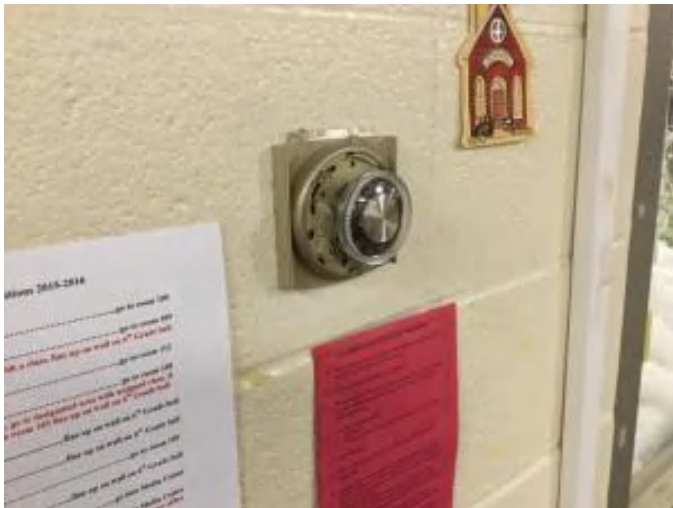
**System: D3060 - Controls & Instrumentation**

**Location:** Throughout the building  
**Distress:** Beyond Service Life  
**Category:** Deferred Maintenance  
**Priority:** 3 - Necessary/Not Yet Critical (Years 2-5)  
**Correction:** Renew System  
**Qty:** 41,625.00  
**Unit of Measure:** S.F.  
**Estimate:** \$87,454.00  
**Assessor Name:** Eduardo Lopez  
**Date Created:** 12/19/2016

**Notes:** HVAC controls in the building are antiquated. Installation of a modern digital system allowing remote monitoring and control is recommended.

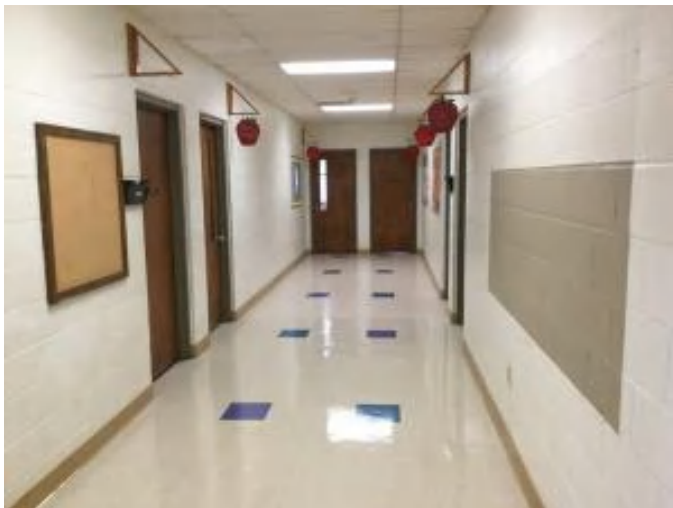
**System: D4010 - Sprinklers**

**Location:** Throughout the building  
**Distress:** Missing  
**Category:** Building Code Compliance  
**Priority:** 3 - Necessary/Not Yet Critical (Years 2-5)  
**Correction:** Renew System  
**Qty:** 41,625.00  
**Unit of Measure:** S.F.  
**Estimate:** \$193,223.00  
**Assessor Name:** Eduardo Lopez  
**Date Created:** 12/19/2016

**Notes:** A wet fire sprinkler system is not installed in this building. Installation of a sprinkler system will mitigate the dead end corridor concern at room 109/111. Installation of a wet fire protection system is recommended.

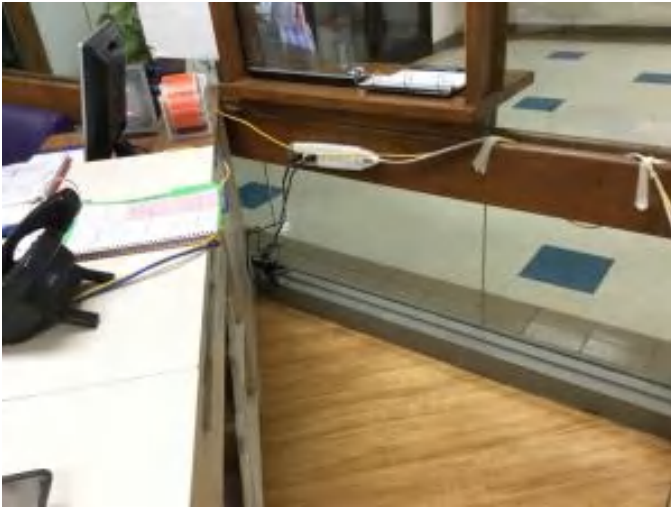
**System: D5020 - Branch Wiring**

**Location:** Throughout the building  
**Distress:** Beyond Service Life  
**Category:** Deferred Maintenance  
**Priority:** 3 - Necessary/Not Yet Critical (Years 2-5)  
**Correction:** Renew System  
**Qty:** 41,625.00  
**Unit of Measure:** S.F.  
**Estimate:** \$228,480.00  
**Assessor Name:** Eduardo Lopez  
**Date Created:** 12/19/2016

**Notes:** The branch wiring system has exceeded its expected useful life. Extension cords are in use around the building. System renewal is recommended.

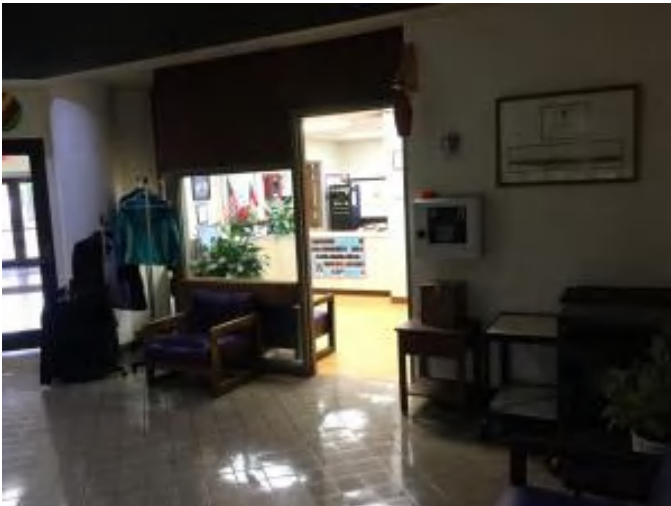
**System: D5020 - Lighting**

**Location:** Throughout the building  
**Distress:** Beyond Service Life  
**Category:** Deferred Maintenance  
**Priority:** 3 - Necessary/Not Yet Critical (Years 2-5)  
**Correction:** Renew System  
**Qty:** 41,625.00  
**Unit of Measure:** S.F.  
**Estimate:** \$532,967.00  
**Assessor Name:** Eduardo Lopez  
**Date Created:** 12/19/2016

**Notes:** Lighting throughout the building is beyond its expected life. The lobby and is particularly dark. System renewal is recommended.

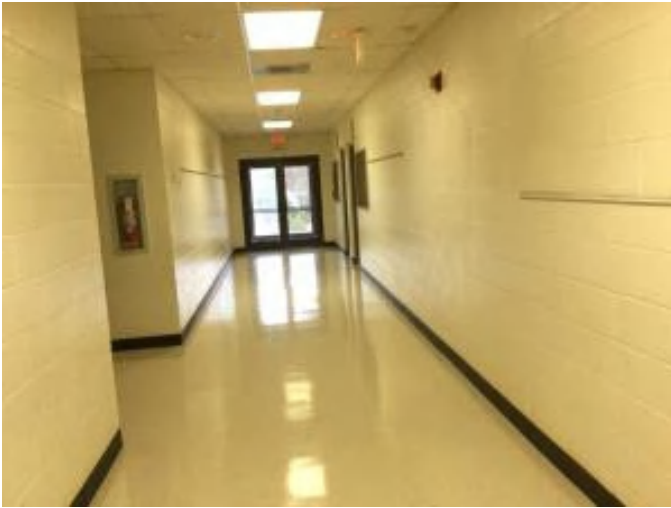
**System: D5030810 - Security & Detection Systems**

**Location:** Throughout the building  
**Distress:** Beyond Service Life  
**Category:** Deferred Maintenance  
**Priority:** 3 - Necessary/Not Yet Critical (Years 2-5)  
**Correction:** Renew System  
**Qty:** 41,625.00  
**Unit of Measure:** S.F.  
**Estimate:** \$83,791.00  
**Assessor Name:** Eduardo Lopez  
**Date Created:** 12/19/2016

**Notes:** The security system does not provide full coverage of all entrances/exits and corridors. System renewal is recommended.

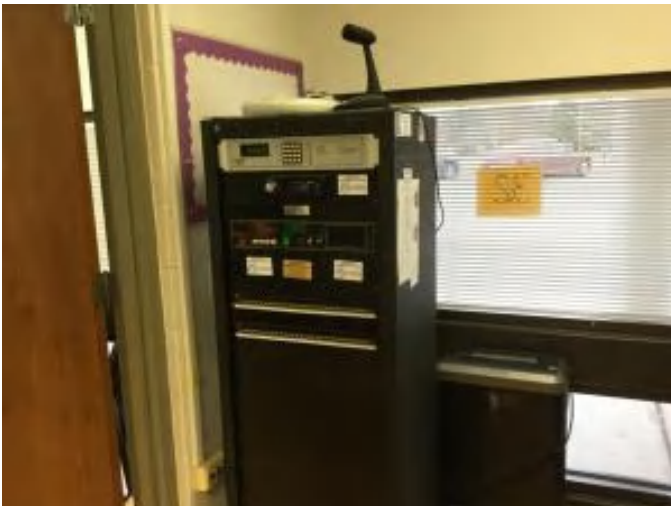
**System: D5030920 - Data Communication**

**Location:** Throughout the building  
**Distress:** Beyond Service Life  
**Category:** Deferred Maintenance  
**Priority:** 3 - Necessary/Not Yet Critical (Years 2-5)  
**Correction:** Renew System  
**Qty:** 41,625.00  
**Unit of Measure:** S.F.  
**Estimate:** \$196,886.00  
**Assessor Name:** Eduardo Lopez  
**Date Created:** 02/10/2017

**Notes:** The PA system is outdated and needs to be replaced. System renewal is recommended.

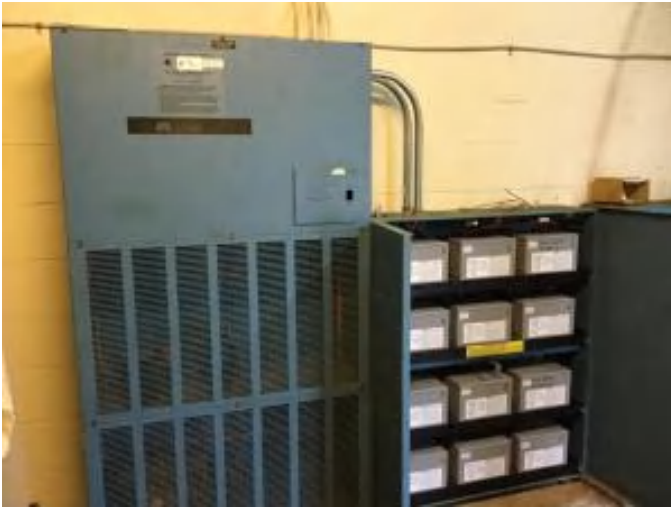
**System: D5090 - Other Electrical Systems**

**Location:** Throughout the building  
**Distress:** Beyond Service Life  
**Category:** Deferred Maintenance  
**Priority:** 3 - Necessary/Not Yet Critical (Years 2-5)  
**Correction:** Renew System  
**Qty:** 41,625.00  
**Unit of Measure:** S.F.  
**Estimate:** \$5,495.00  
**Assessor Name:** Eduardo Lopez  
**Date Created:** 12/19/2016

**Notes:** Emergency and exit lighting is beyond its expected life. The battery back-up system is obsolete and high maintenance. Exit signage is missing in some locations. System renewal is recommended.

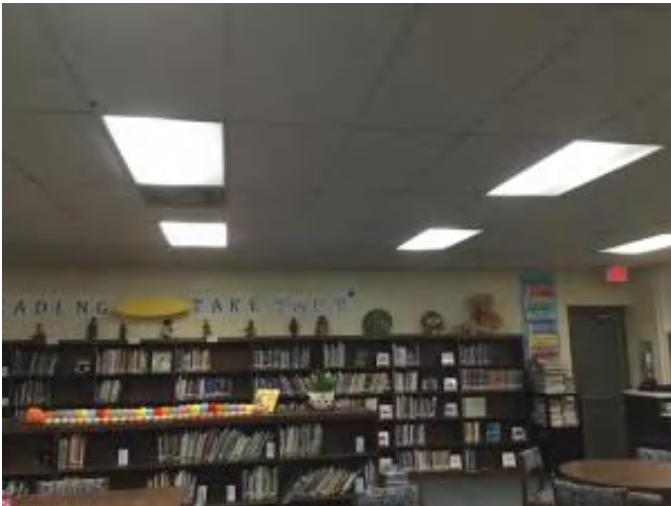
**System: F1020 - Institutional Equipment**

**Location:** Media Center  
**Distress:** Beyond Service Life  
**Category:** Deferred Maintenance  
**Priority:** 3 - Necessary/Not Yet Critical (Years 2-5)  
**Correction:** Renew System  
**Qty:** 41,625.00  
**Unit of Measure:** S.F.  
**Estimate:** \$13,736.00  
**Assessor Name:** Eduardo Lopez  
**Date Created:** 12/19/2016

**Notes:** Library and other institutional equipment is original and beyond its expected life. System renewal is recommended.

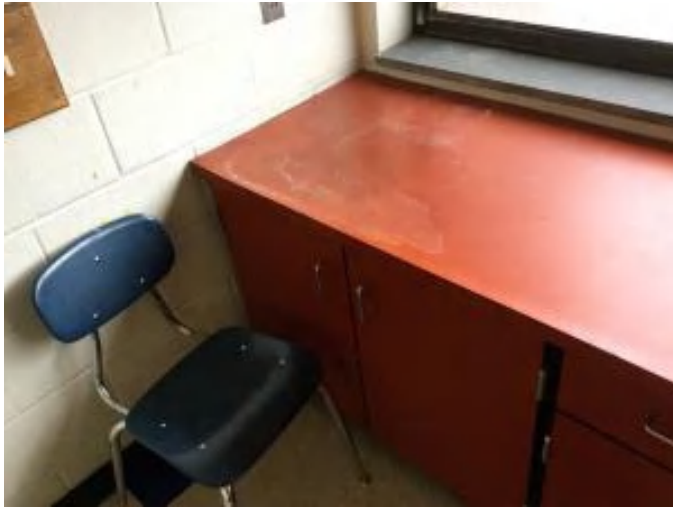
**System: E2010 - Fixed Furnishings**

**Location:** Throughout the building  
**Distress:** Beyond Service Life  
**Category:** Deferred Maintenance  
**Priority:** 3 - Necessary/Not Yet Critical (Years 2-5)  
**Correction:** Renew System  
**Qty:** 41,625.00  
**Unit of Measure:** S.F.  
**Estimate:** \$261,905.00  
**Assessor Name:** Eduardo Lopez  
**Date Created:** 12/19/2016

**Notes:** Fixed furnishings are beyond their expected life and in fair to poor condition. Renew system.

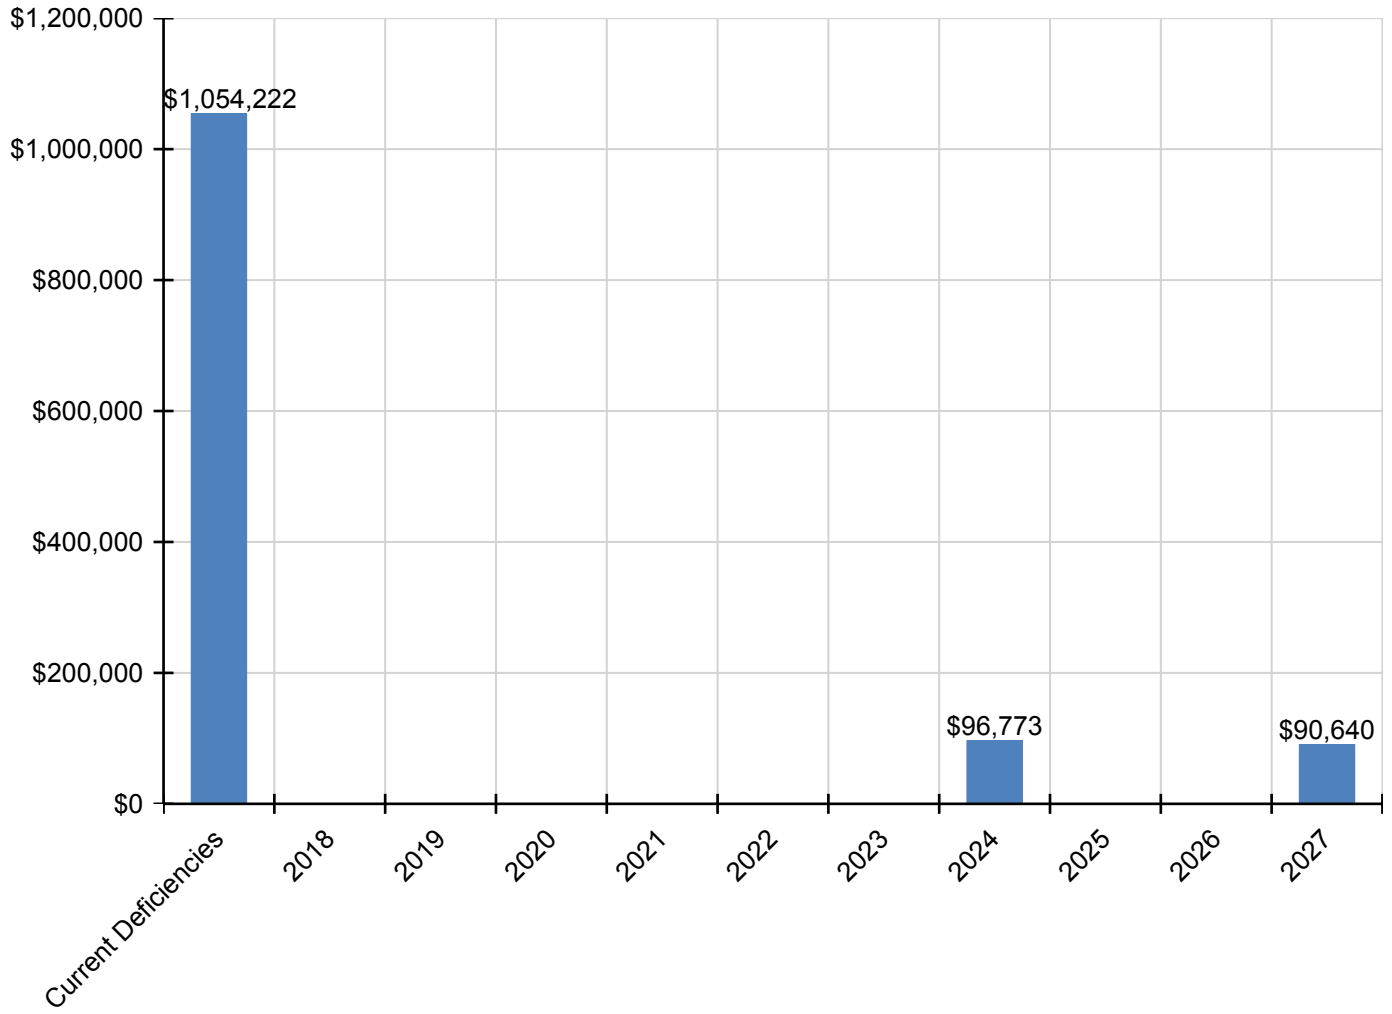
## Forecasted Capital Renewal Requirement

The following chart shows the current building deficiencies and forecasting capital renewal or sustainment requirements over the next ten years.

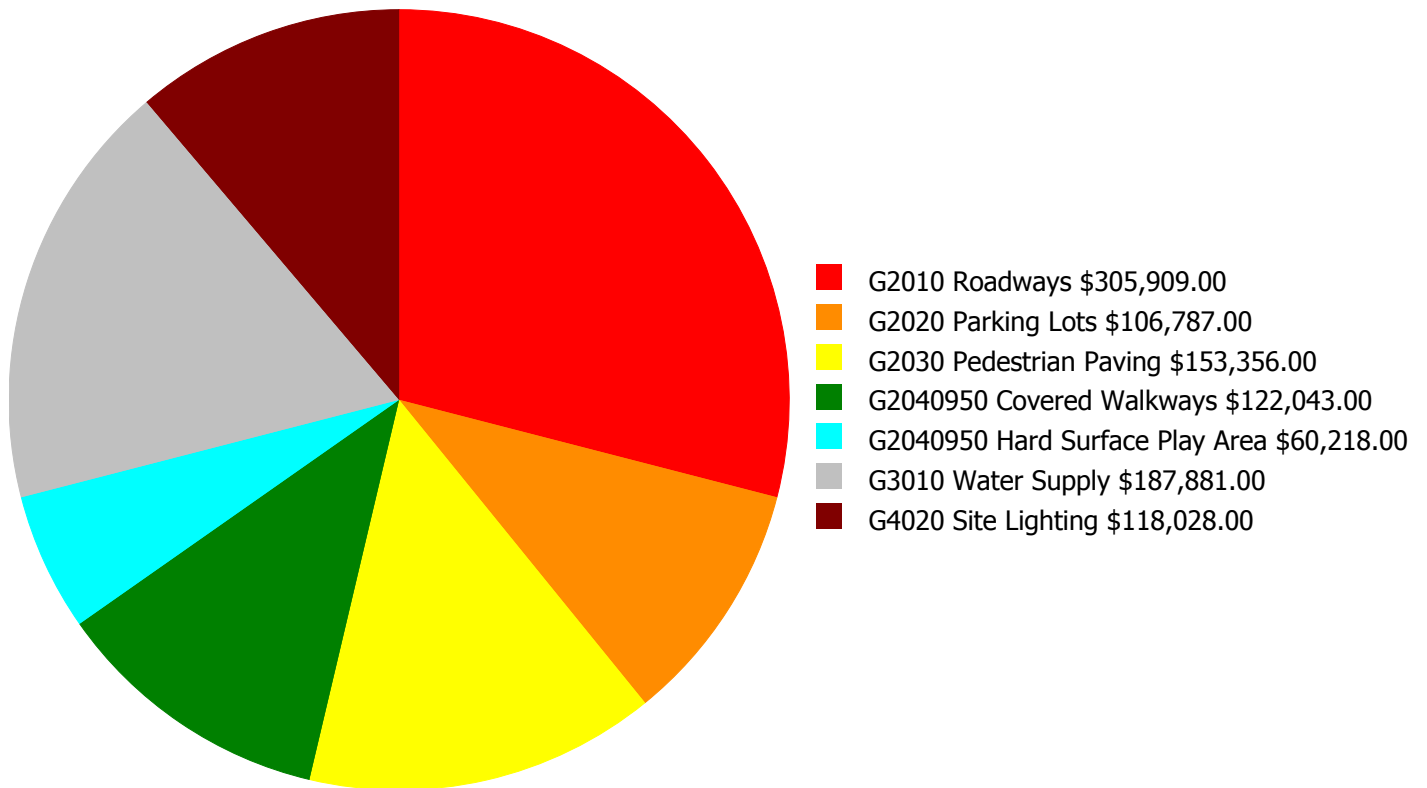
## Deficiency Summary by System

Current deficiencies included assemblies that have reached or exceeded their design life or components of the assemblies that are in need of repair. Assemblies that have reached their design life are identified as current deficiencies and assigned the distress 'Beyond Useful Life'. The following chart lists all current deficiencies associated with this facility.

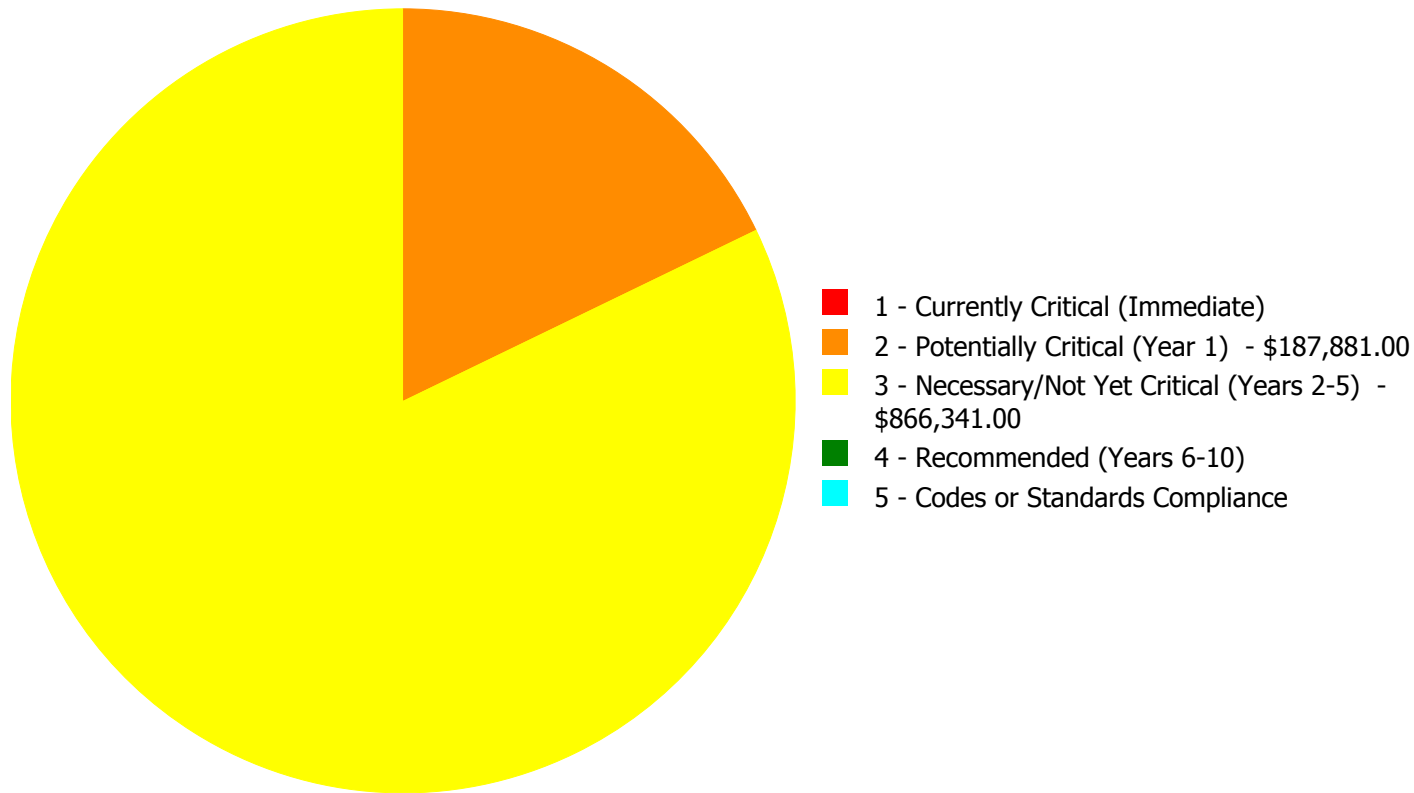
### Deficiency Summary by Priority

The following chart shows the total repair costs broken down by priority. Assessors assigned deficiencies within eCOMET to one of the following priority categories:

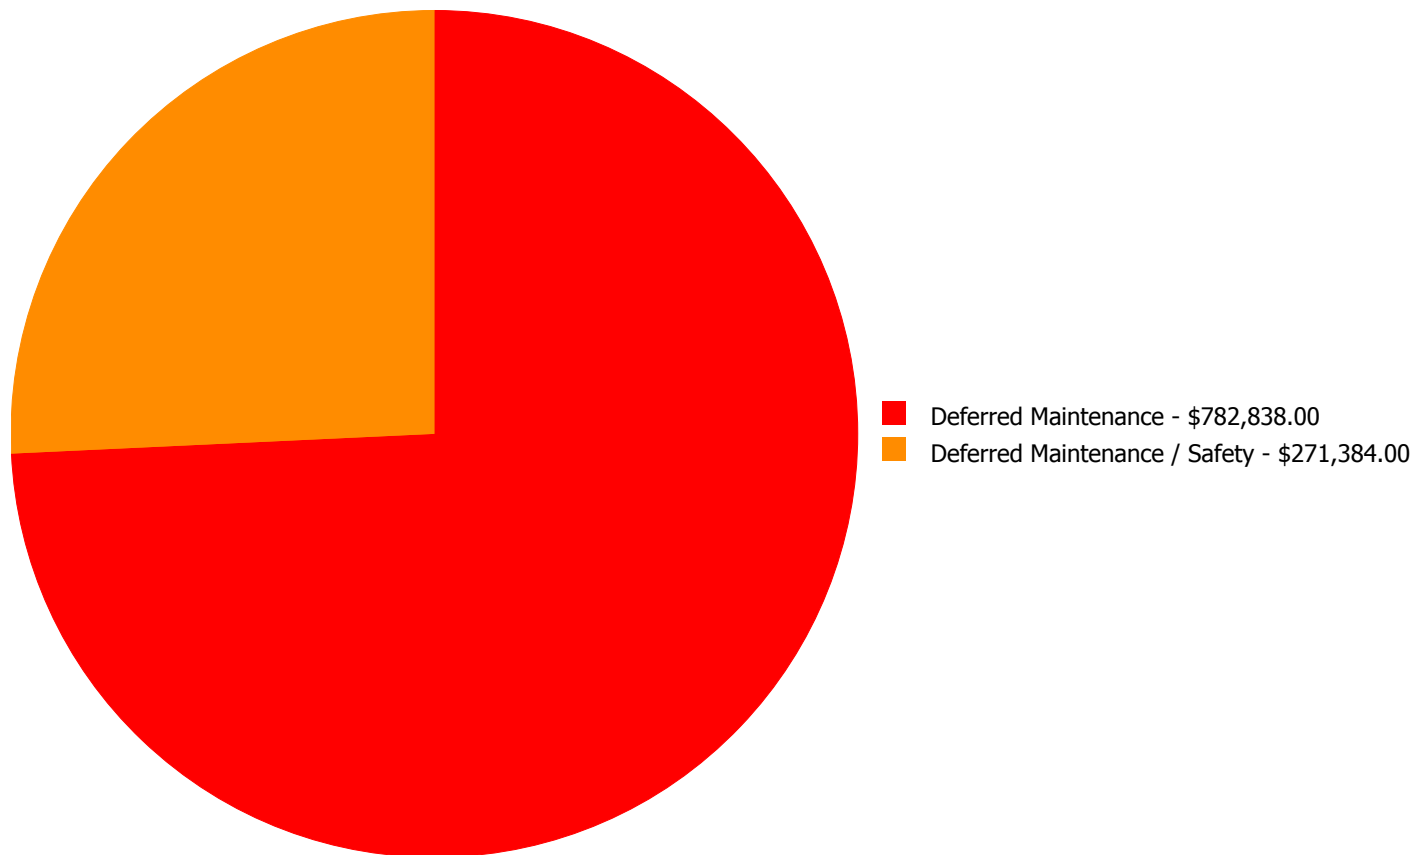
### Deficiency Summary by Category

The following chart shows the total repair costs broken down by deficiency categories. Assessors assigned deficiencies to one of the following categories:

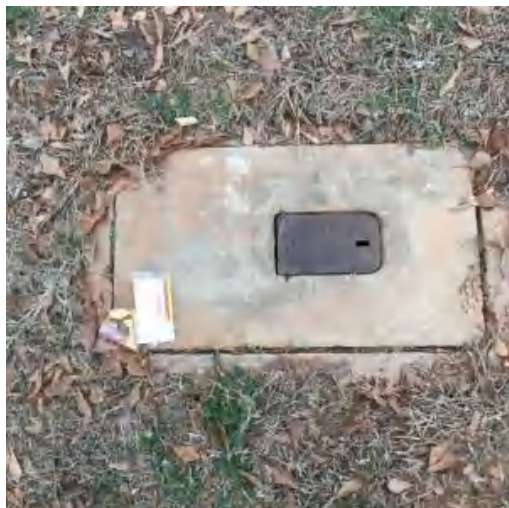
#### System: G3010 - Water Supply

**Location:** Site  
**Distress:** Inadequate  
**Category:** Deferred Maintenance  
**Priority:** 2 - Potentially Critical (Year 1)  
**Correction:** Renew System  
**Qty:** 72,992.00  
**Unit of Measure:** S.F.  
**Estimate:** \$187,881.00  
**Assessor Name:** Ann Buerger Linden  
**Date Created:** 02/10/2017

**Notes:** The City water supply does not provide sufficient water flow at all times for the campus. There is no backflow preventer on the supply. System renewal is recommended.

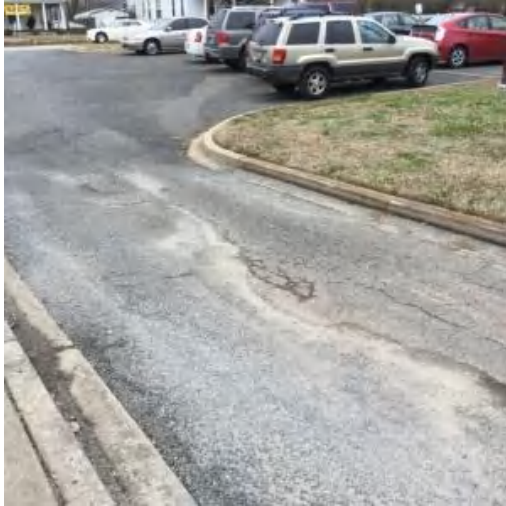
**System: G2010 - Roadways**

**Location:** Site  
**Distress:** Beyond Service Life  
**Category:** Deferred Maintenance  
**Priority:** 3 - Necessary/Not Yet Critical (Years 2-5)  
**Correction:** Renew System  
**Qty:** 72,992.00  
**Unit of Measure:** S.F.  
**Estimate:** \$305,909.00  
**Assessor Name:** Ann Buerger Linden  
**Date Created:** 02/09/2017

**Notes:** Entrance drives are cracked and the surface is grainy, it is beyond its scheduled life expectancy. System renewal is recommended.

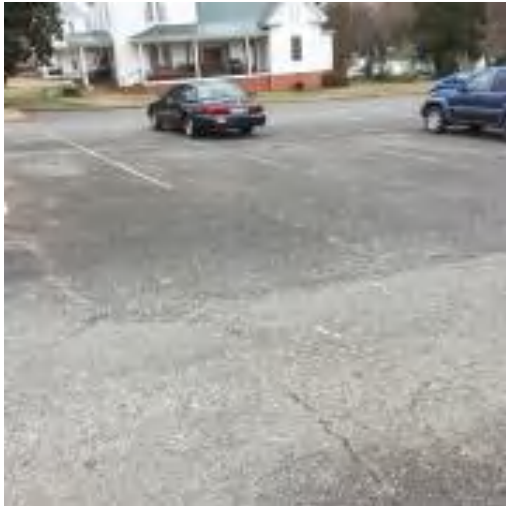
**System: G2020 - Parking Lots**

**Location:** Site  
**Distress:** Beyond Service Life  
**Category:** Deferred Maintenance  
**Priority:** 3 - Necessary/Not Yet Critical (Years 2-5)  
**Correction:** Renew System  
**Qty:** 72,992.00  
**Unit of Measure:** S.F.  
**Estimate:** \$106,787.00  
**Assessor Name:** Ann Buerger Linden  
**Date Created:** 02/09/2017

**Notes:** The upper parking lot has cracks and the surface is grainy. It is past its expected life. The lower lot serving Anson Academy is unpaved. System renewal is recommended.

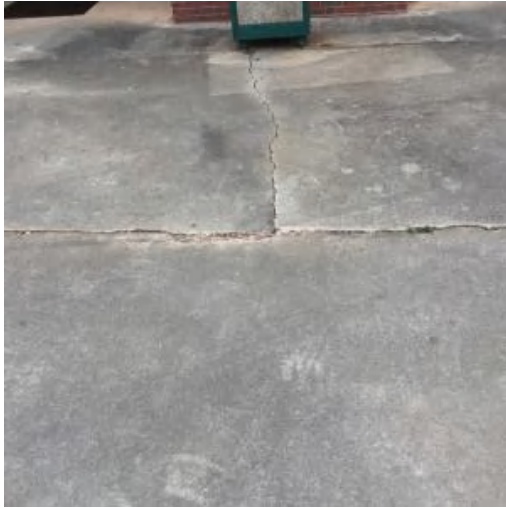
**System: G2030 - Pedestrian Paving**

**Location:** Site  
**Distress:** Beyond Service Life  
**Category:** Deferred Maintenance / Safety  
**Priority:** 3 - Necessary/Not Yet Critical (Years 2-5)  
**Correction:** Renew System  
**Qty:** 72,992.00  
**Unit of Measure:** S.F.  
**Estimate:** \$153,356.00  
**Assessor Name:** Ann Buerger Linden  
**Date Created:** 02/09/2017

**Notes:** Site sidewalks are in fair condition with some cracking. The city sidewalk used to access the gym building is adjacent to a high traffic street and a path closer to the building should be built. Exterior stairs behind the gym do not have handrails. System renewal is recommended.

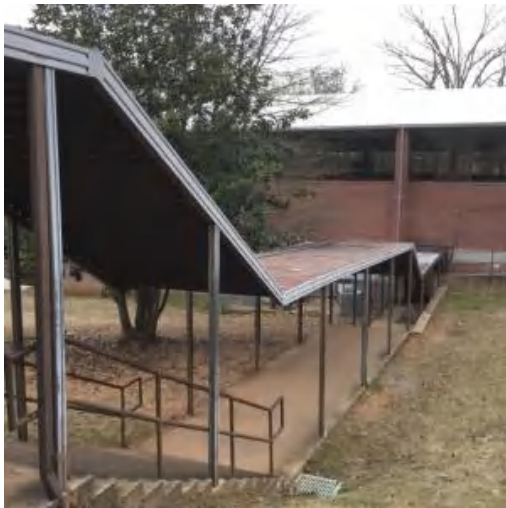
**System: G2040950 - Covered Walkways**

**Location:** Main to Gym and Main to Cafeteria  
**Distress:** Beyond Service Life  
**Category:** Deferred Maintenance  
**Priority:** 3 - Necessary/Not Yet Critical (Years 2-5)  
**Correction:** Renew System  
**Qty:** 72,992.00  
**Unit of Measure:** S.F.  
**Estimate:** \$122,043.00  
**Assessor Name:** Ann Buerger Linden  
**Date Created:** 02/09/2017

**Notes:** Covered walkways are beyond their expected life. Lighting is not present on the walkway to the gym building. Lighting between the building and the cafeteria is yellowed and expired.

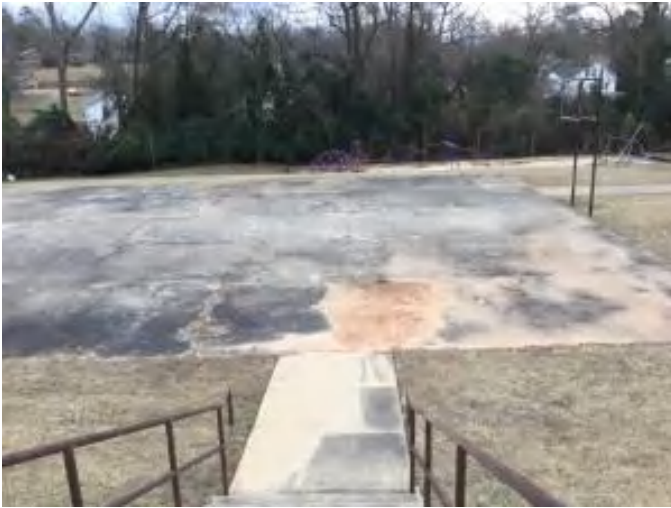
**System: G2040950 - Hard Surface Play Area**

**Location:** On site east of building  
**Distress:** Beyond Service Life  
**Category:** Deferred Maintenance  
**Priority:** 3 - Necessary/Not Yet Critical (Years 2-5)  
**Correction:** Renew System  
**Qty:** 72,992.00  
**Unit of Measure:** S.F.  
**Estimate:** \$60,218.00  
**Assessor Name:** Ann Buerger Linden  
**Date Created:** 02/09/2017

**Notes:** The hard surfaced play area is in decrepit condition. Backstops are not functional. System renewal is recommended.

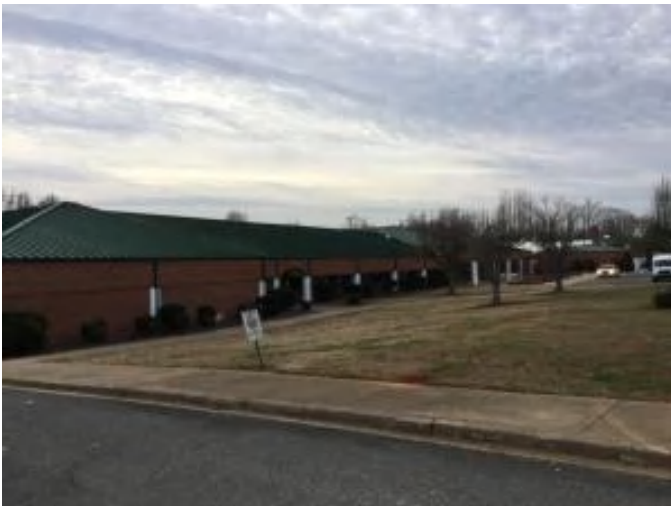
**System: G4020 - Site Lighting**

**Location:** Site  
**Distress:** Beyond Service Life  
**Category:** Deferred Maintenance / Safety  
**Priority:** 3 - Necessary/Not Yet Critical (Years 2-5)  
**Correction:** Renew System  
**Qty:** 72,992.00  
**Unit of Measure:** S.F.  
**Estimate:** \$118,028.00  
**Assessor Name:** Ann Buerger Linden  
**Date Created:** 02/09/2017

**Notes:** Site lighting is beyond its expected life where it exists. There is insufficient lighting at the front of the building, at the rear of the building, and at the lower parking lot. System renewal is recommended.

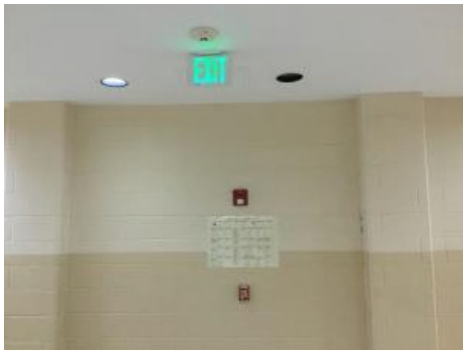
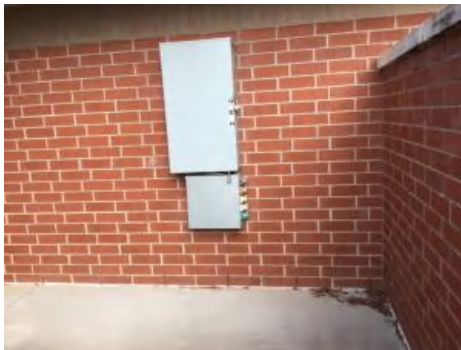
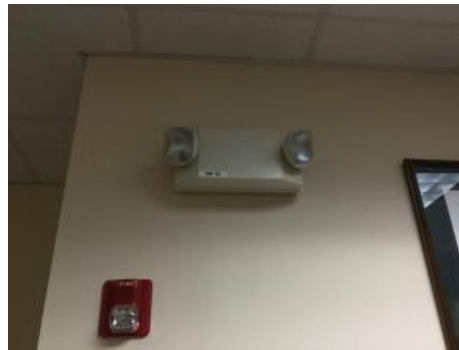
### System: D5090 - Other Electrical Systems

**Note:** School has transfer switch for emergency generator. Portable generator supplied by local emergency response team as needed. School was previously a designated emergency shelter site.

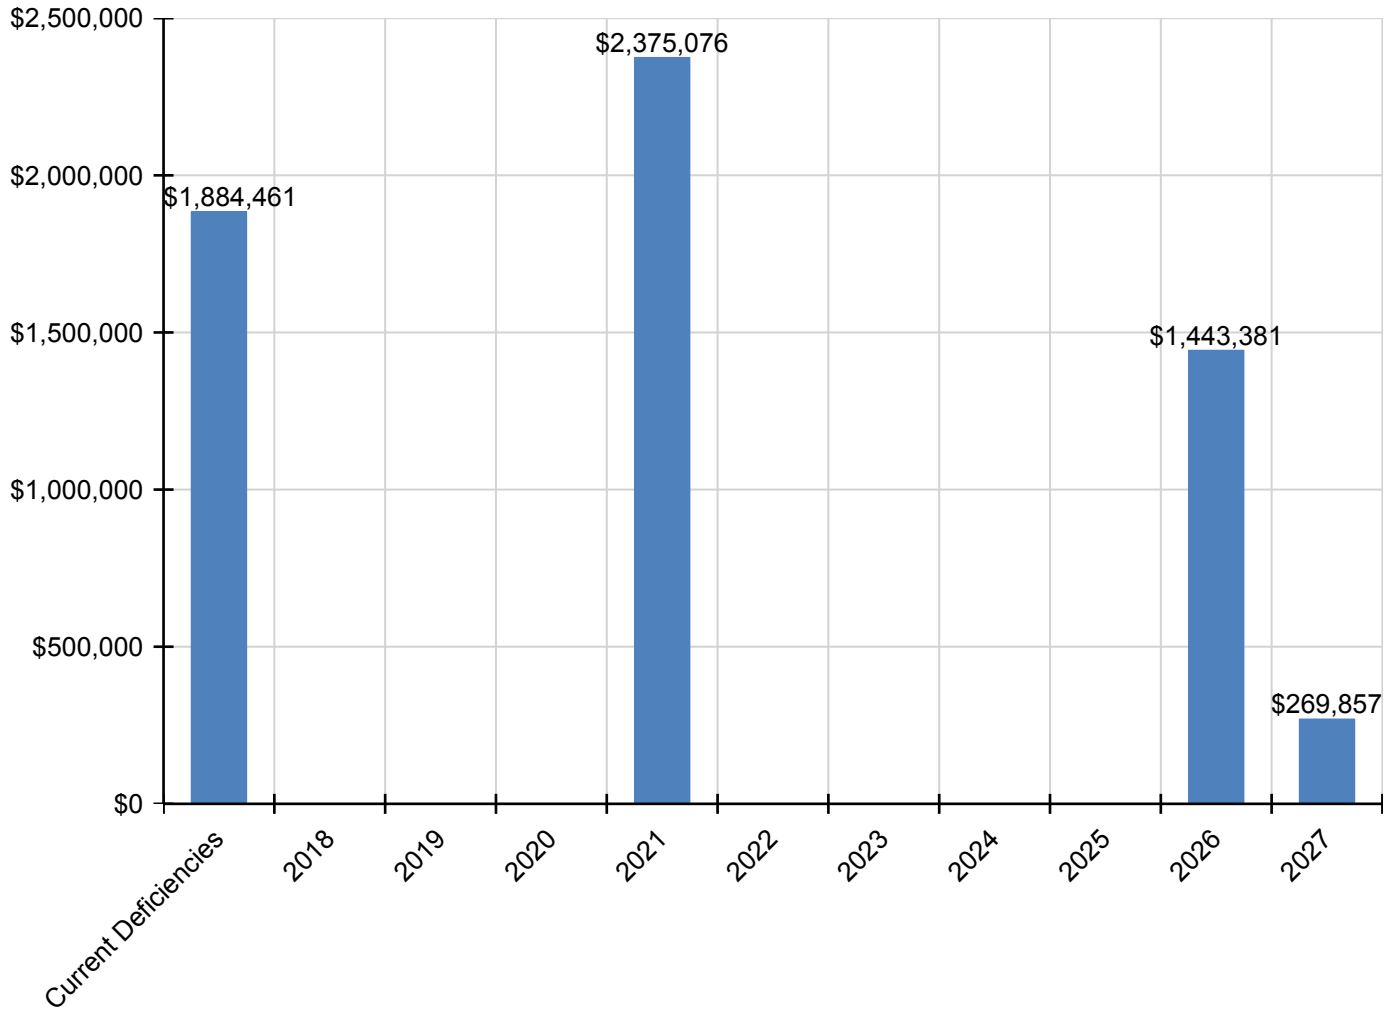
## Forecasted Capital Renewal Requirement

The following chart shows the current building deficiencies and forecasting capital renewal or sustainment requirements over the next ten years.

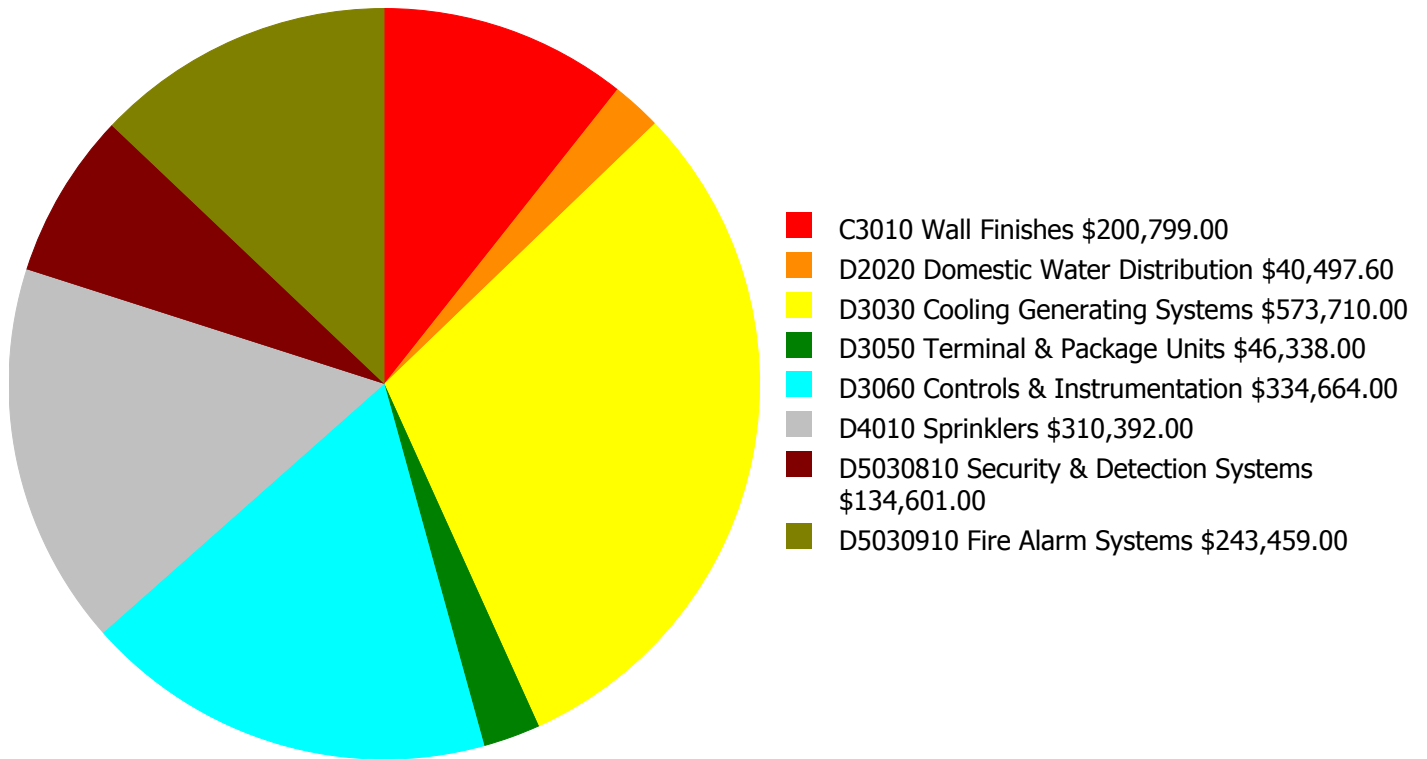
## Deficiency Summary by System

Current deficiencies included assemblies that have reached or exceeded their design life or components of the assemblies that are in need of repair. Assemblies that have reached their design life are identified as current deficiencies and assigned the distress 'Beyond Useful Life'. The following chart lists all current deficiencies associated with this facility.

**Budget Estimate Total: \$1,884,460.60**

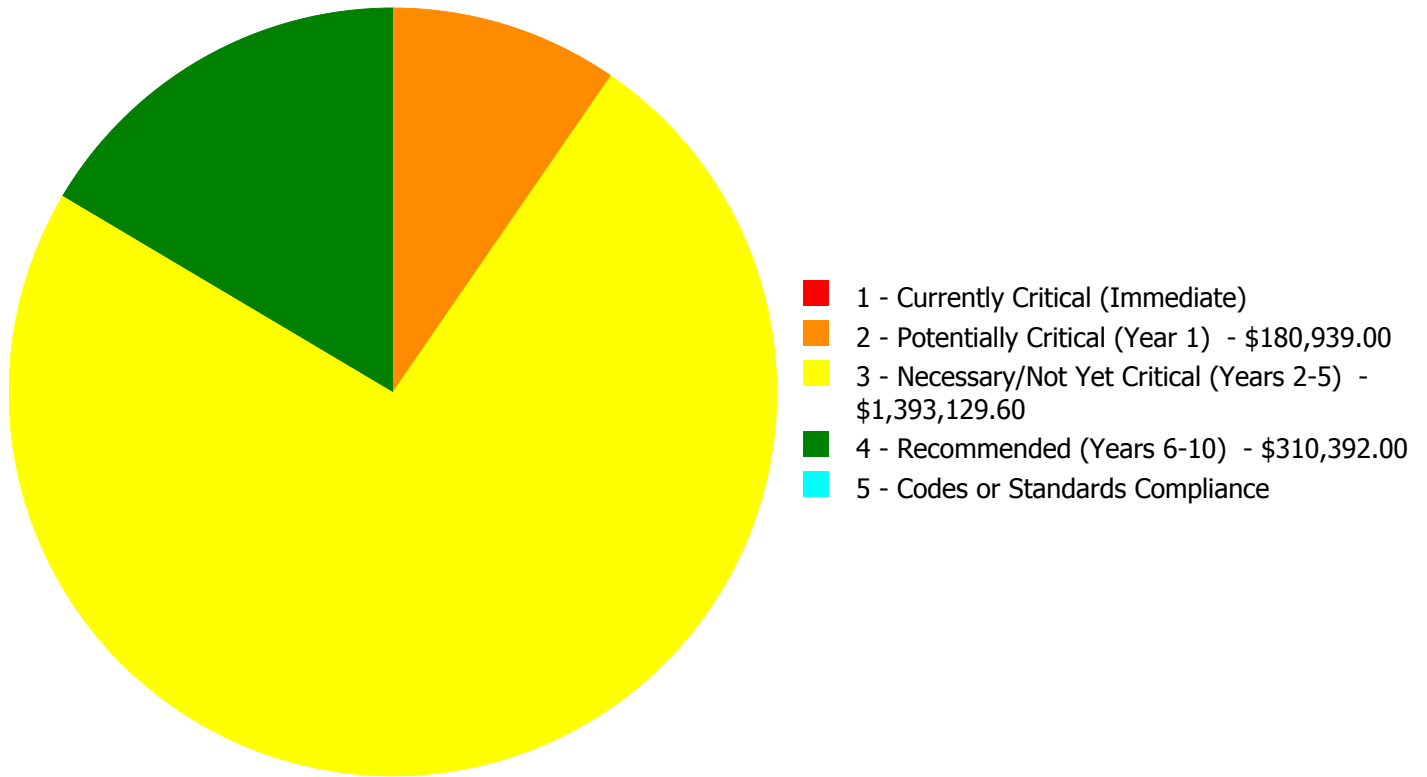
## Deficiency Summary by Priority

The following chart shows the total repair costs broken down by priority. Assessors assigned deficiencies within eCOMET to one of the following priority categories:

**Budget Estimate Total: \$1,884,460.60**

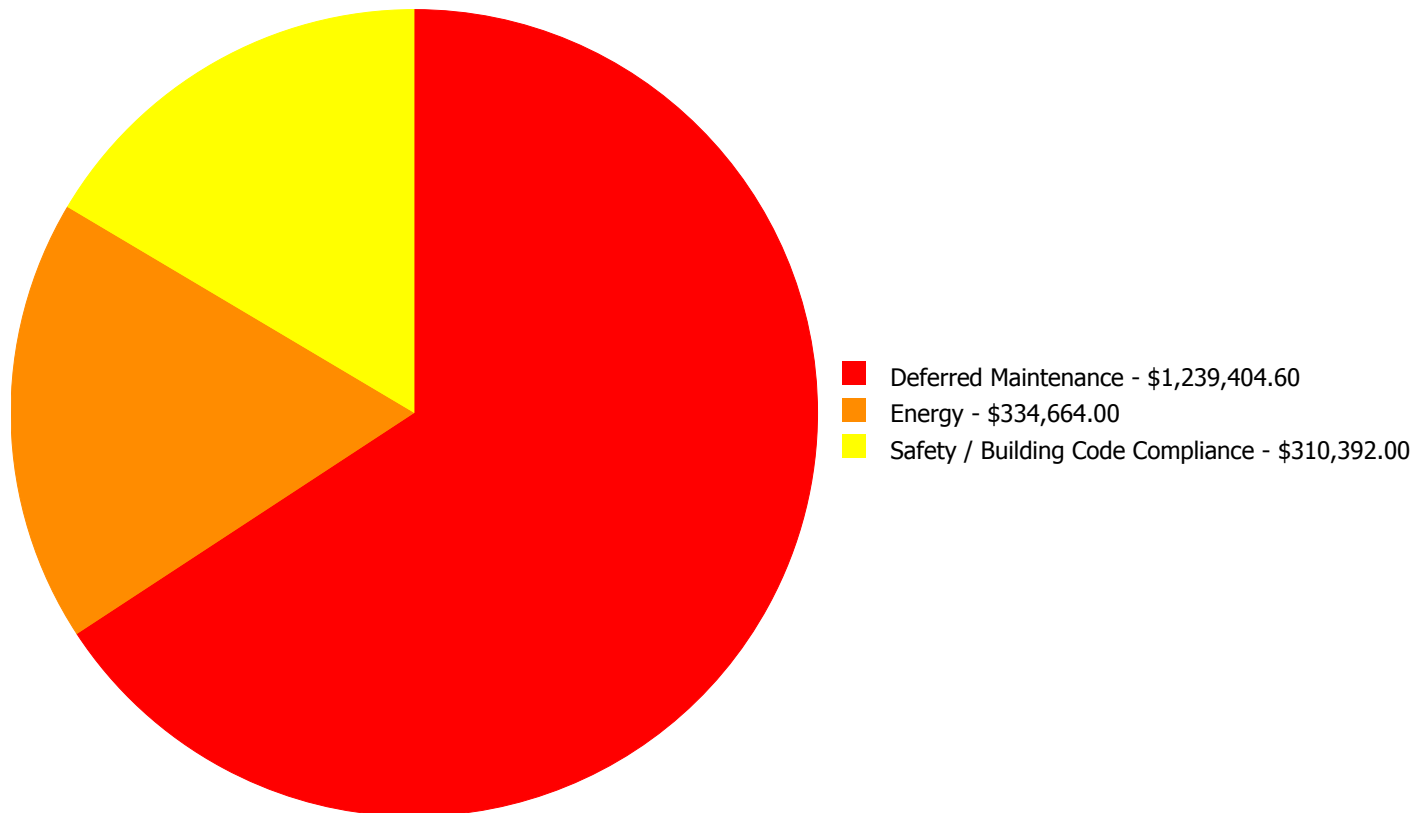
## Deficiency Summary by Category

The following chart shows the total repair costs broken down by deficiency categories. Assessors assigned deficiencies to one of the following categories:

**Budget Estimate Total: \$1,884,460.60**

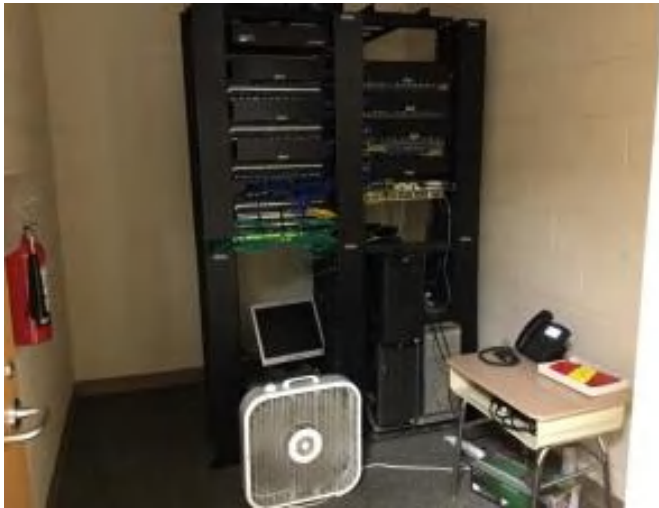
**System: D3050 - Terminal & Package Units**

**Location:** Data rooms  
**Distress:** Inadequate  
**Category:** Deferred Maintenance  
**Priority:** 2 - Potentially Critical (Year 1)  
**Correction:** Renew System  
**Qty:** 66,866.00  
**Unit of Measure:** S.F.  
**Estimate:** \$46,338.00  
**Assessor Name:** Somnath Das  
**Date Created:** 12/16/2016

**Notes:** Data rooms do not have independent cooling. The building system is inadequate for these spaces. Provide mini-split systems.

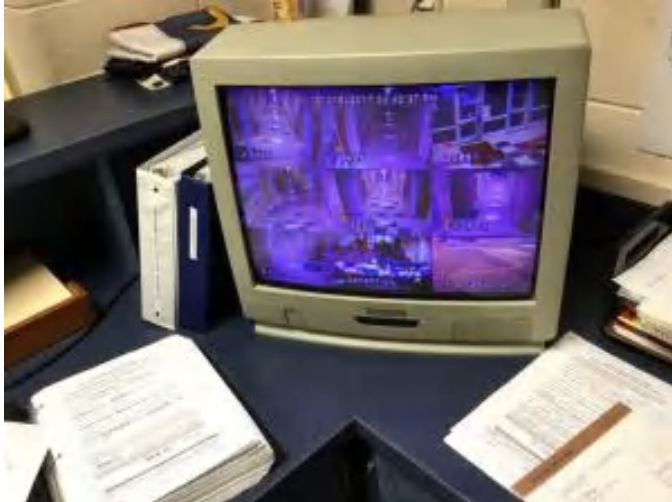
**System: D5030810 - Security & Detection Systems**

**Location:** Throughout the building  
**Distress:** Beyond Service Life  
**Category:** Deferred Maintenance  
**Priority:** 2 - Potentially Critical (Year 1)  
**Correction:** Renew System  
**Qty:** 66,866.00  
**Unit of Measure:** S.F.  
**Estimate:** \$134,601.00  
**Assessor Name:** Somnath Das  
**Date Created:** 12/16/2016

**Notes:** The original security system is obsolete and does not function well. A digital system is requested. Additional cameras needed at bus lot and front of building.

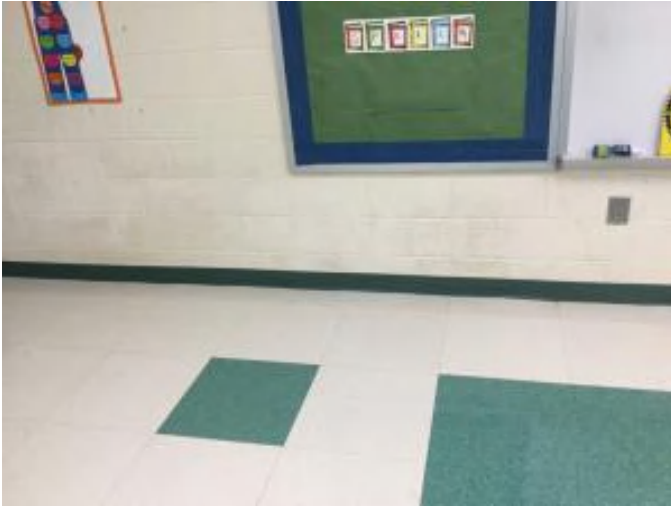
**System: C3010 - Wall Finishes**

**Location:** Throughout the building.  
**Distress:** Beyond Service Life  
**Category:** Deferred Maintenance  
**Priority:** 3 - Necessary/Not Yet Critical (Years 2-5)  
**Correction:** Renew System  
**Qty:** 66,866.00  
**Unit of Measure:** S.F.  
**Estimate:** \$200,799.00  
**Assessor Name:** Somnath Das  
**Date Created:** 12/16/2016

**Notes:** Painted walls are maintained on an ad hoc basis with no regularly scheduled repainting. Many areas of the building are in need of re-painting. System renewal is recommended

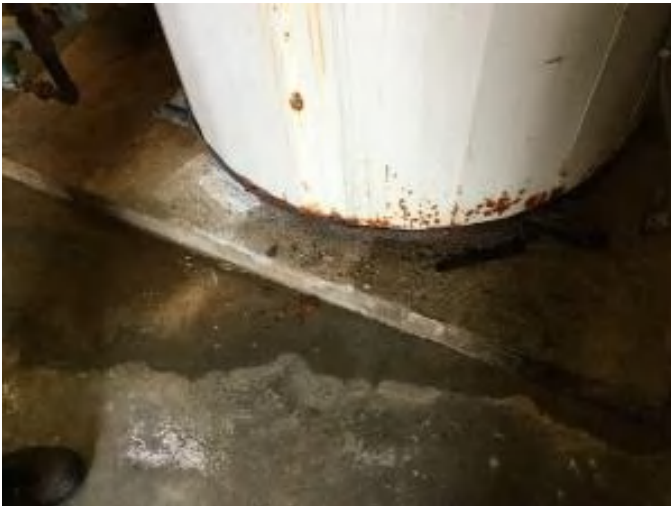
**System: D2020 - Domestic Water Distribution**

**Location:** Mechanical room  
**Distress:** Beyond Service Life  
**Category:** Deferred Maintenance  
**Priority:** 3 - Necessary/Not Yet Critical (Years 2-5)  
**Correction:** Replace water heater, gas / oil, 70 gallon  
**Qty:** 2.00  
**Unit of Measure:** Ea.  
**Estimate:** \$40,497.60  
**Assessor Name:** Somnath Das  
**Date Created:** 02/08/2017

**Notes:** Water heaters are beyond their expected service life. Replacement is recommended.
