# Anson Middle

## Campus Assessment Report

March 7, 2017

## Campus Assessment Report - 1966 Building, Cafe/Gym

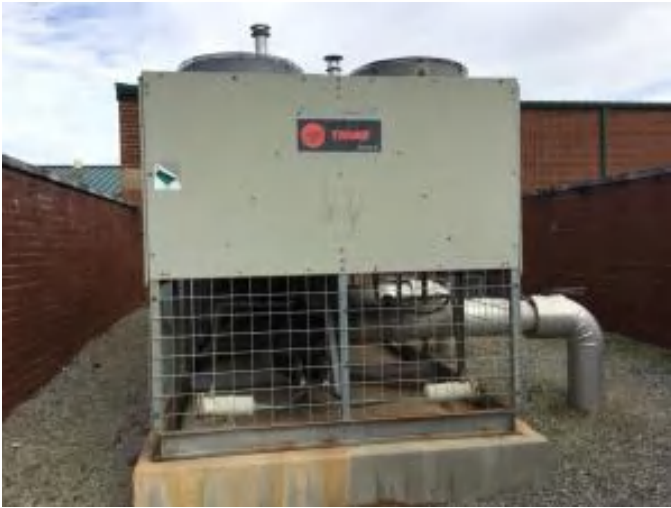
**System: D3030 - Cooling Generating Systems**

**Location:** Air cooled chiller  
**Distress:** Beyond Service Life  
**Category:** Deferred Maintenance  
**Priority:** 3 - Necessary/Not Yet Critical (Years 2-5)  
**Correction:** Renew System  
**Qty:** 66,866.00  
**Unit of Measure:** S.F.  
**Estimate:** \$573,710.00  
**Assessor Name:** Somnath Das  
**Date Created:** 02/08/2017

**Notes:** The original chiller has had 2 major failures. System renewal for reliability is recommended.

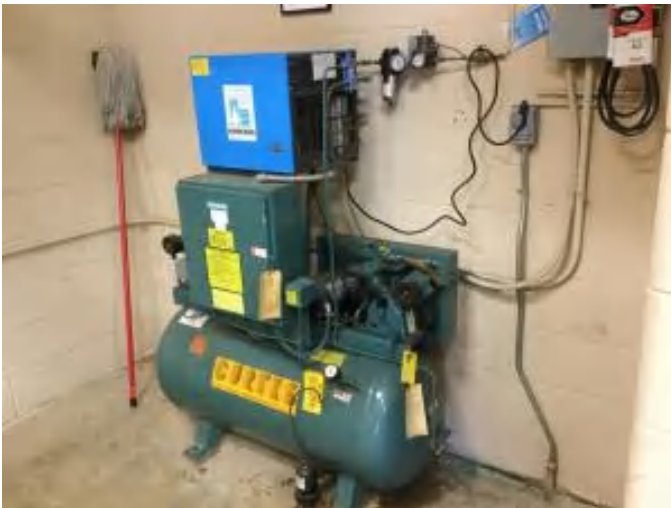
**System: D3060 - Controls & Instrumentation**

**Location:** Throughout the building  
**Distress:** Inadequate  
**Category:** Energy  
**Priority:** 3 - Necessary/Not Yet Critical (Years 2-5)  
**Correction:** Renew System  
**Qty:** 66,866.00  
**Unit of Measure:** S.F.  
**Estimate:** \$334,664.00  
**Assessor Name:** Somnath Das  
**Date Created:** 02/08/2017

**Notes:** The original pneumatic controls system was obsolete at the time of construction. Replacement with a digital controls system that allows remote monitoring and control is recommended for system efficiency and reliability.

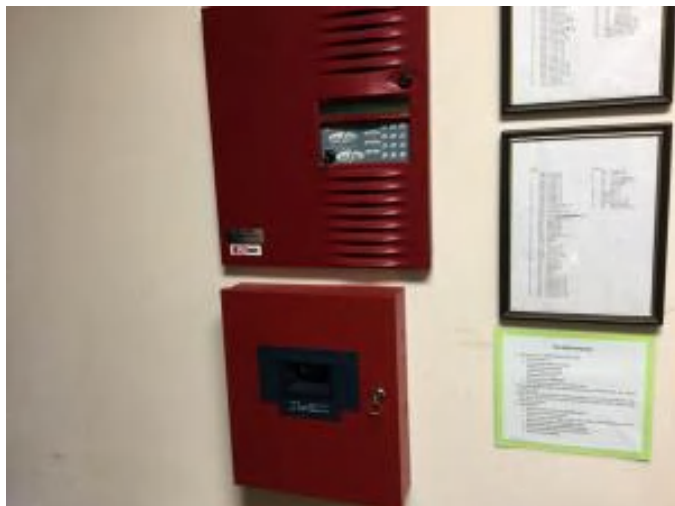
**System: D5030910 - Fire Alarm Systems**

**Location:** Throughout the building  
**Distress:** Beyond Service Life  
**Category:** Deferred Maintenance  
**Priority:** 3 - Necessary/Not Yet Critical (Years 2-5)  
**Correction:** Renew System  
**Qty:** 66,866.00  
**Unit of Measure:** S.F.  
**Estimate:** \$243,459.00  
**Assessor Name:** Somnath Das  
**Date Created:** 12/16/2016

**Notes:** The fire alarm system is original and beyond its expected life. Replacement parts are difficult to obtain. System renewal is recommended to ensure reliability of this life safety system.

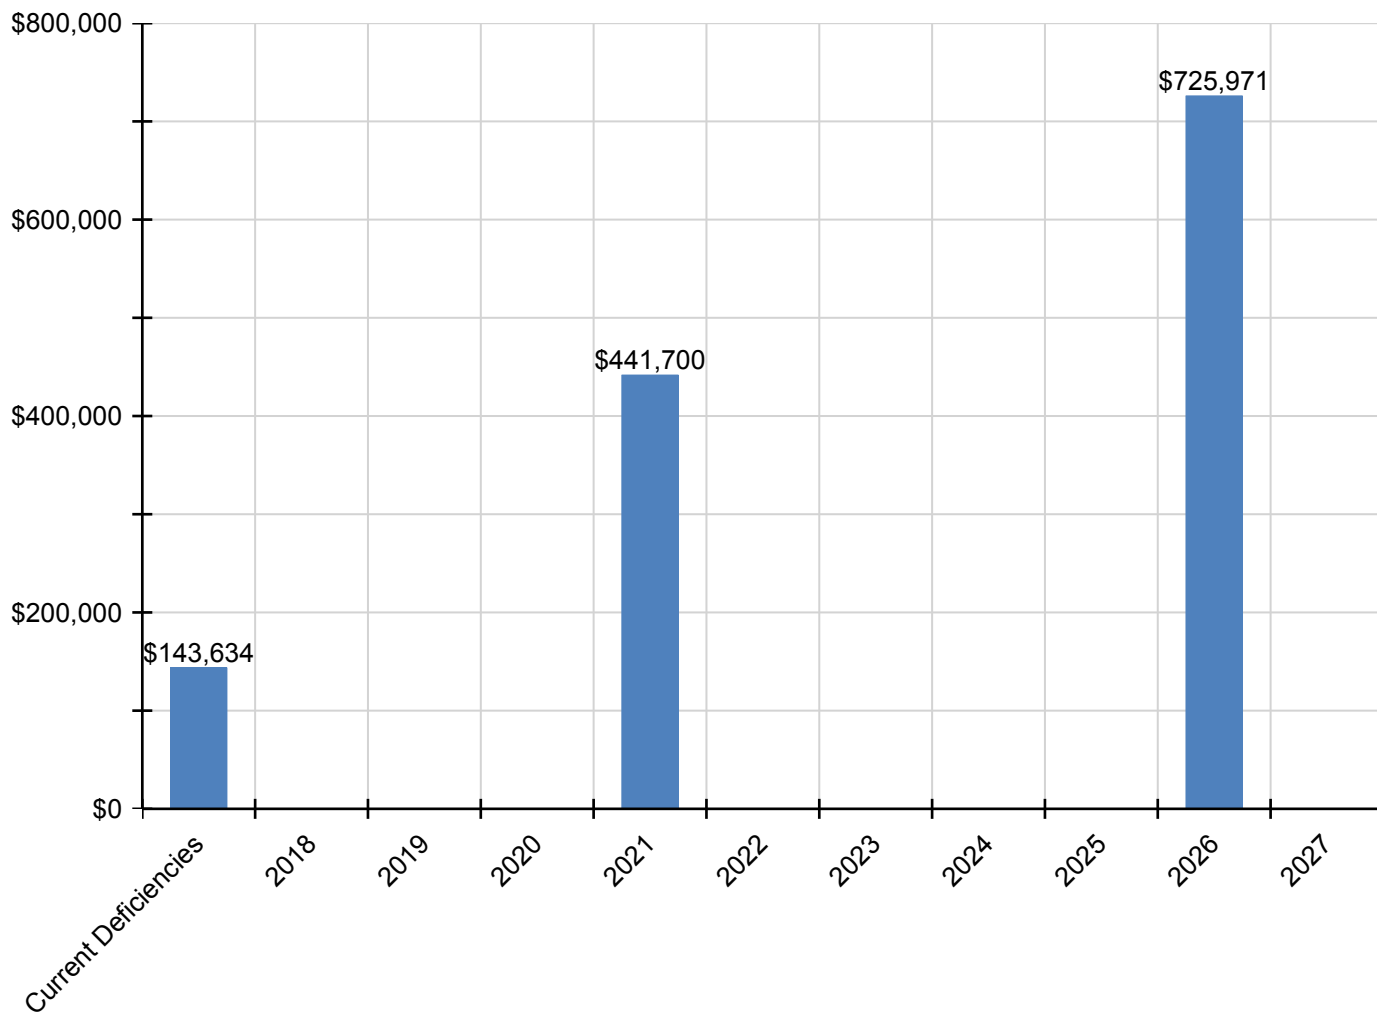
## Forecasted Capital Renewal Requirement

The following chart shows the current building deficiencies and forecasting capital renewal or sustainment requirements over the next ten years.

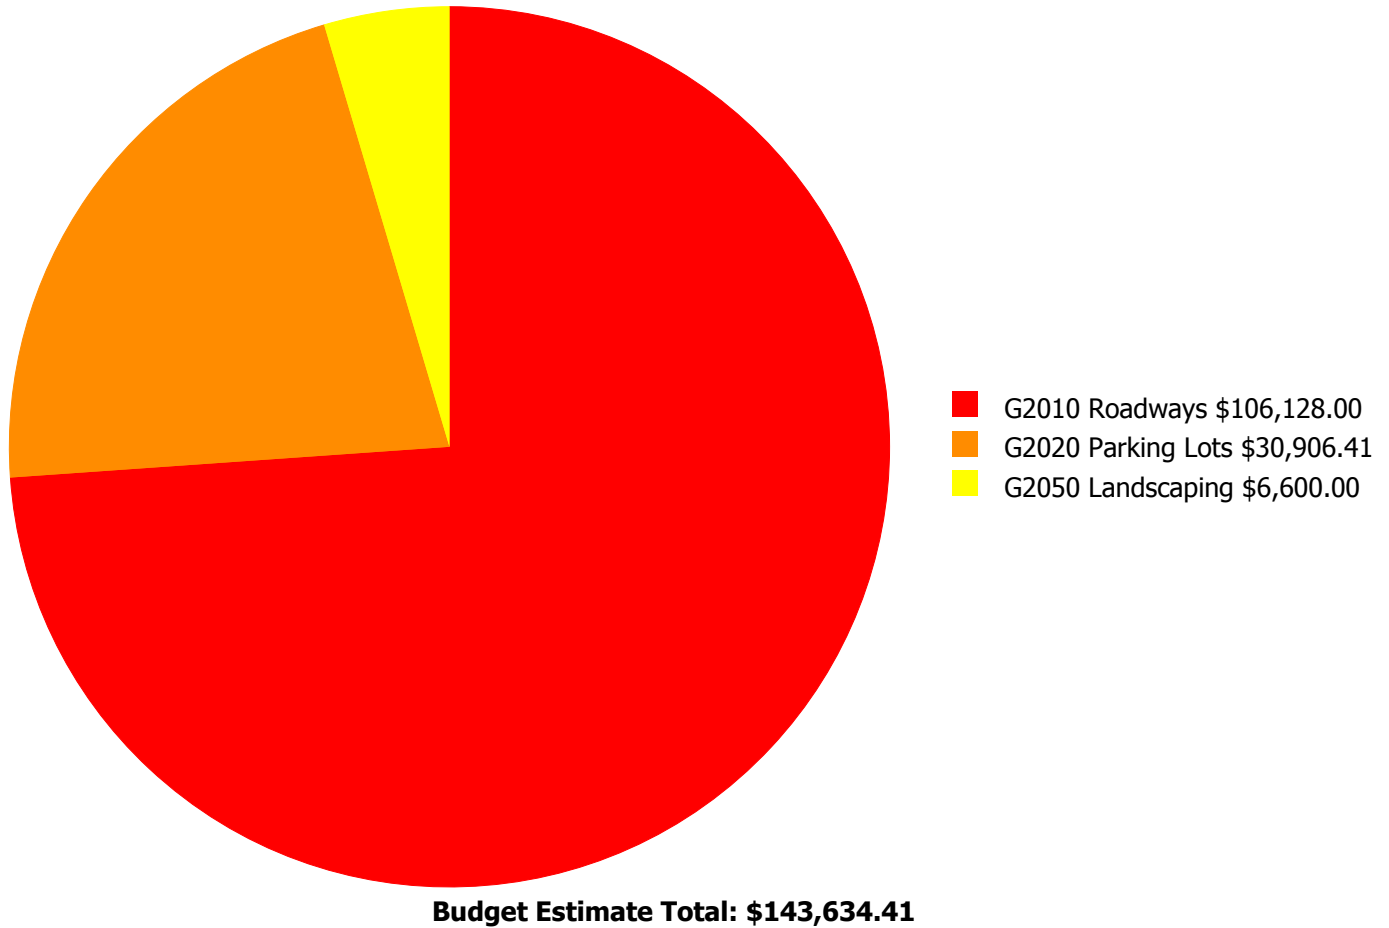
## Deficiency Summary by System

Current deficiencies included assemblies that have reached or exceeded their design life or components of the assemblies that are in need of repair. Assemblies that have reached their design life are identified as current deficiencies and assigned the distress 'Beyond Useful Life'. The following chart lists all current deficiencies associated with this facility.

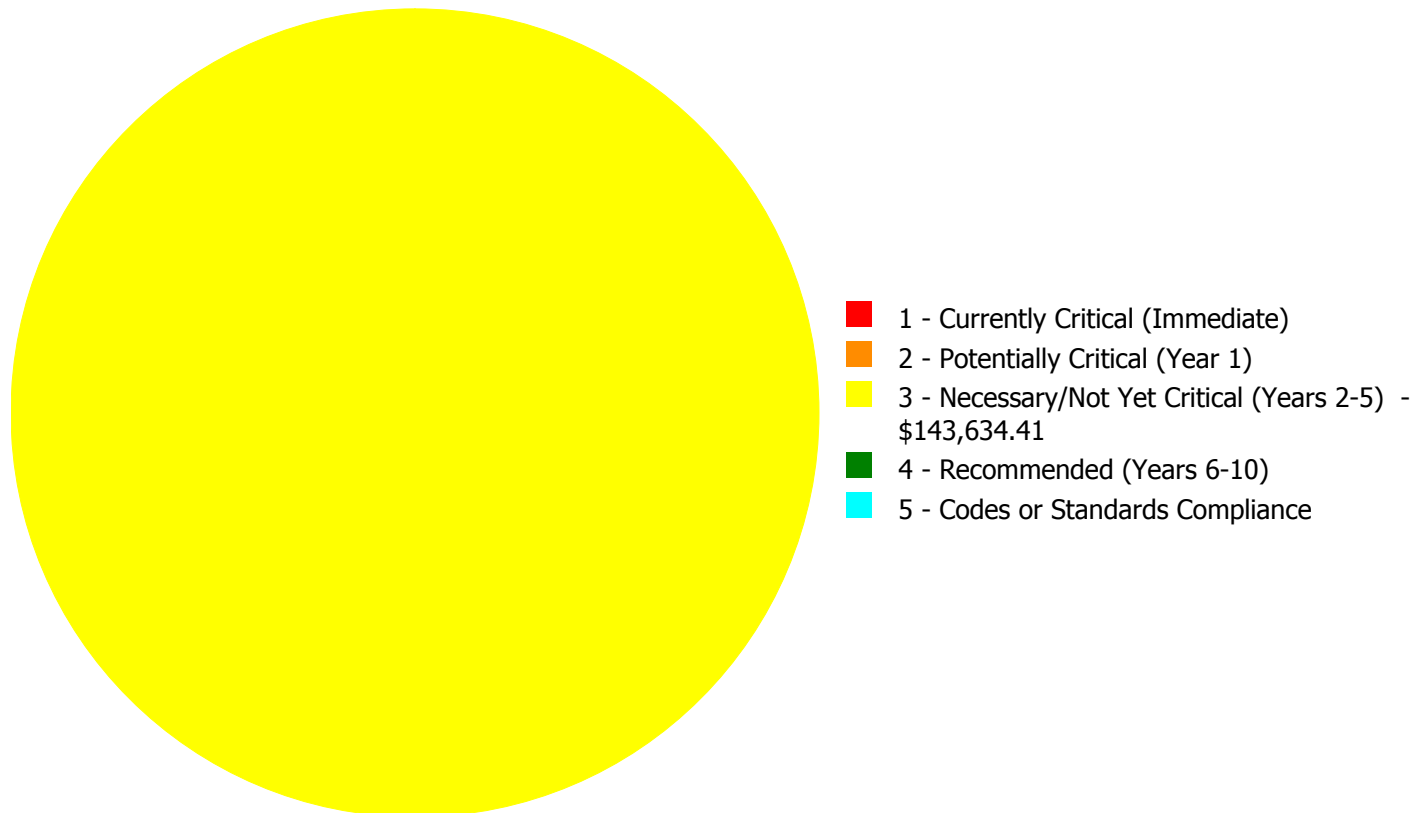
## Deficiency Summary by Priority

The following chart shows the total repair costs broken down by priority. Assessors assigned deficiencies within eCOMET to one of the following priority categories:

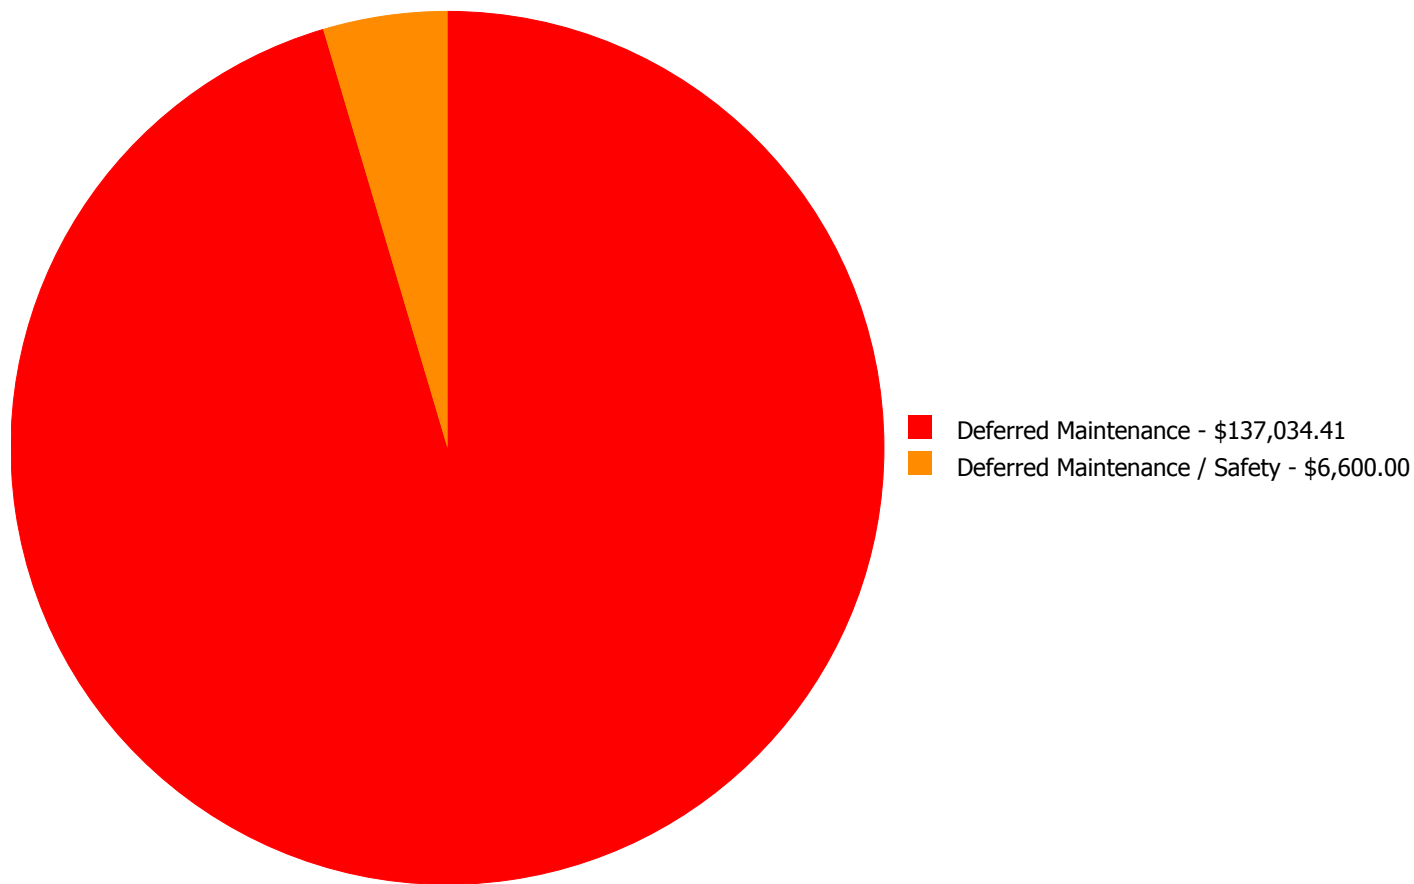
## Deficiency Summary by Category

The following chart shows the total repair costs broken down by deficiency categories. Assessors assigned deficiencies to one of the following categories:

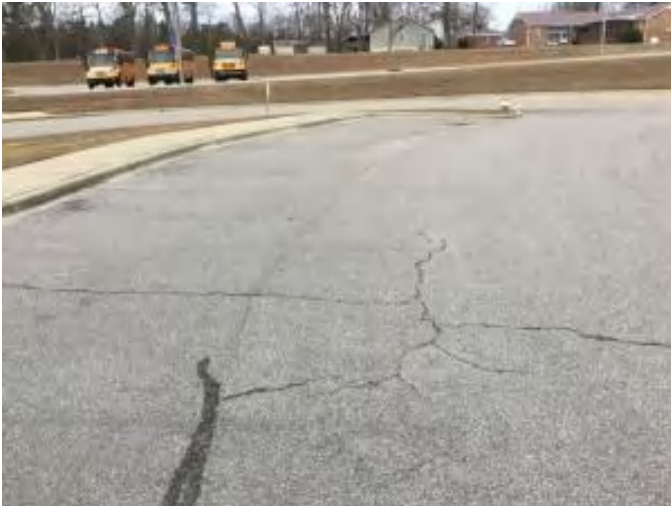
#### System: G2010 - Roadways

**Location:** Site roadways  
**Distress:** Failing  
**Category:** Deferred Maintenance  
**Priority:** 3 - Necessary/Not Yet Critical (Years 2-5)  
**Correction:** Resurface the roadway  
**Qty:** 2,500.00  
**Unit of Measure:** L.F.  
**Estimate:** \$106,128.00  
**Assessor Name:** Somnath Das  
**Date Created:** 02/08/2017

**Notes:** Roads are alligatored and grainy. Crack sealing and sealing is recommended to prolong system life.

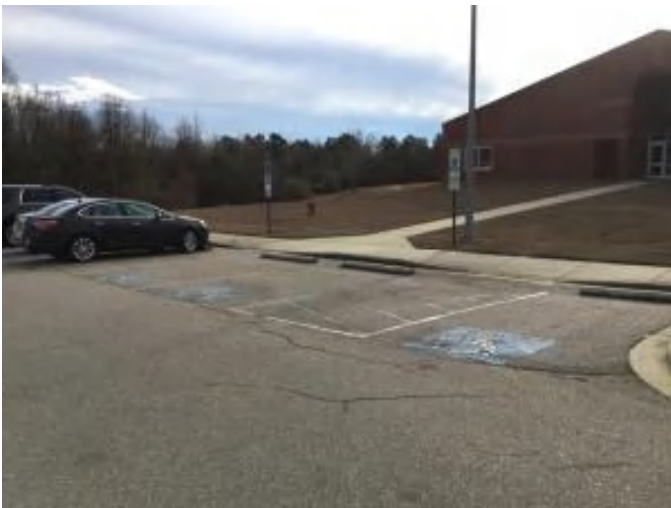
#### System: G2020 - Parking Lots

**Location:** Parking lots  
**Distress:** Failing  
**Category:** Deferred Maintenance  
**Priority:** 3 - Necessary/Not Yet Critical (Years 2-5)  
**Correction:** Parking lot repair and sealcoating  
**Qty:** 35.00  
**Unit of Measure:** M.S.F.  
**Estimate:** \$30,906.41  
**Assessor Name:** Somnath Das  
**Date Created:** 02/08/2017

**Notes:** Parking lots show some alligatored and asphalt is grainy. Striping and pavement markings are faded. Crack fill and seal pavements. Re-stripe lots.

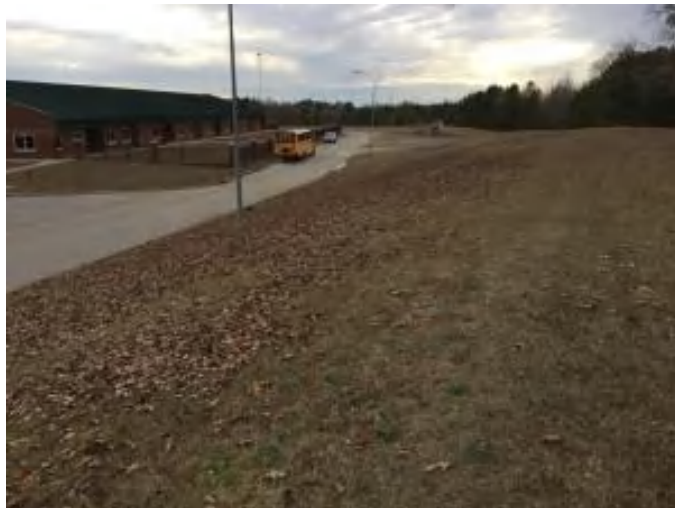
**System: G2050 - Landscaping**

**Location:** Near bus driveway  
**Distress:** Inadequate  
**Category:** Deferred Maintenance / Safety  
**Priority:** 3 - Necessary/Not Yet Critical (Years 2-5)  
**Correction:** Grading study  
**Qty:** 1.00  
**Unit of Measure:** Ea.  
**Estimate:** \$6,600.00  
**Assessor Name:** Somnath Das  
**Date Created:** 02/09/2017

**Notes:** The steep slope north of the bus drive area spills runoff and debris onto the pavement, creating icy conditions in winter. Regrading is recommended.

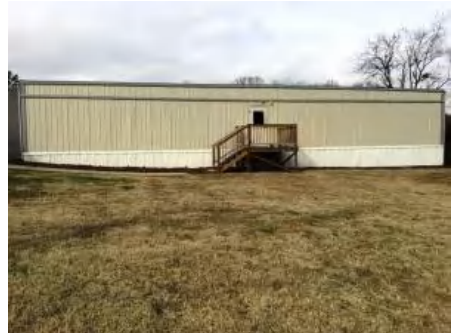
3). South Elevation - Jan 19, 2017

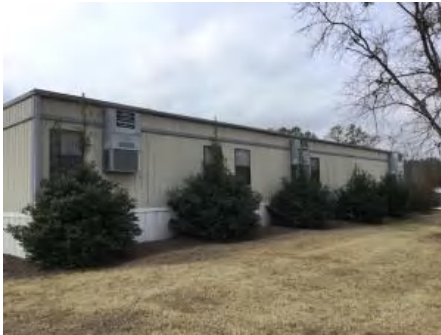
4). Southeast Elevation - Jan 19, 2017

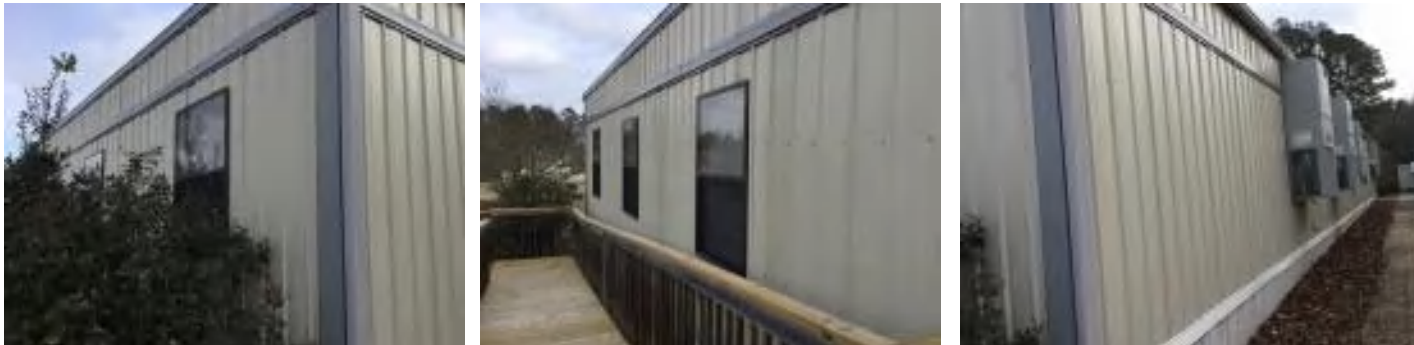
**System:** B2010 - Exterior Walls

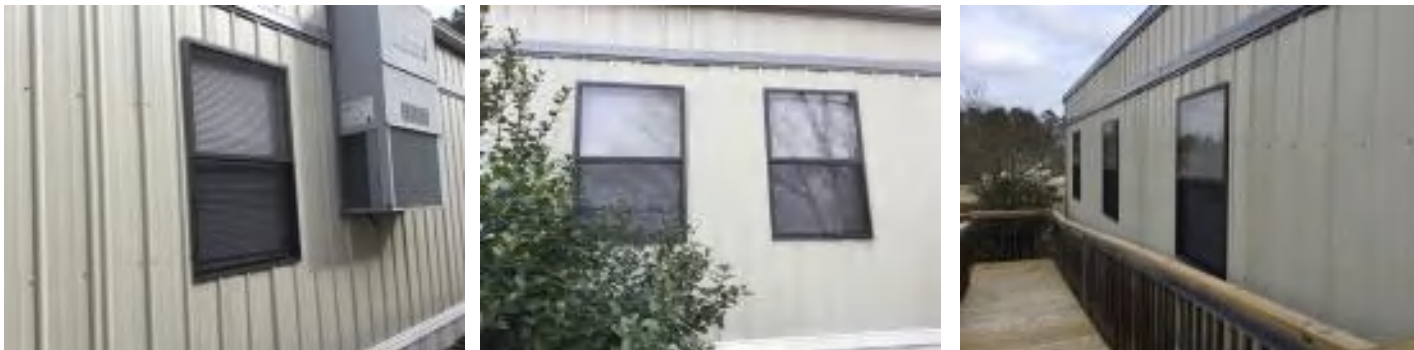
**System:** B2020 - Exterior Windows

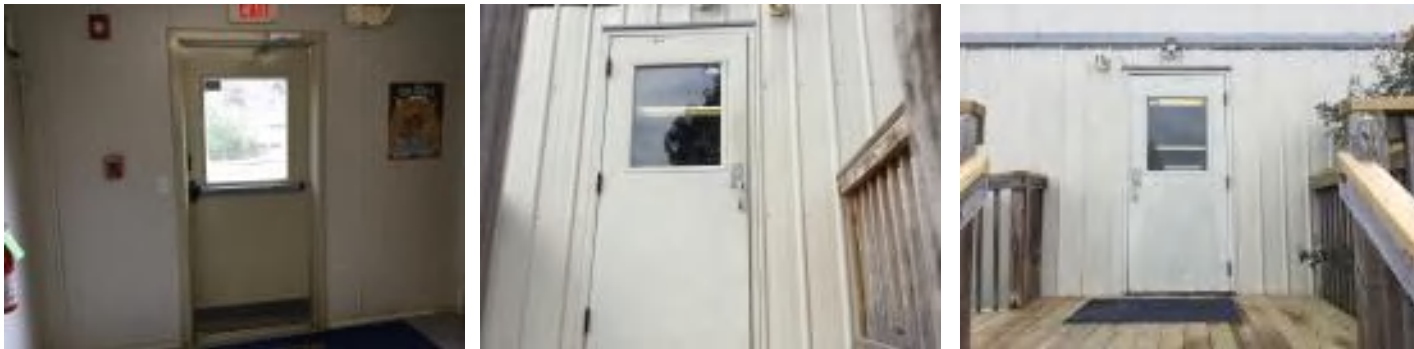
**System:** B2030 - Exterior Doors

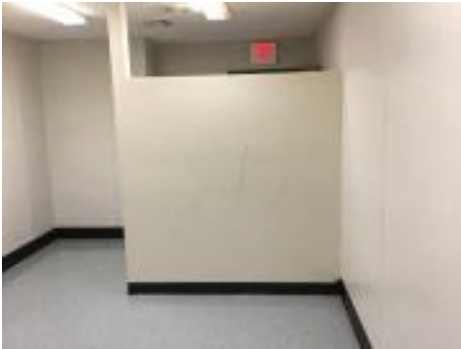
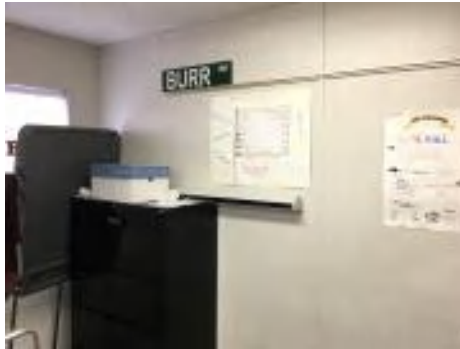
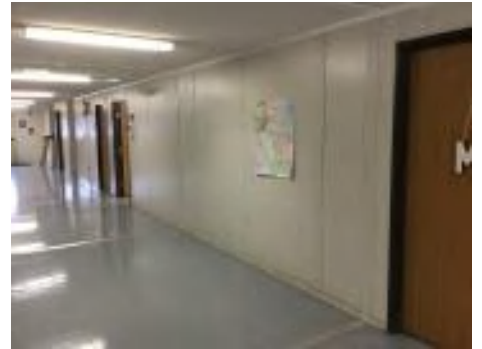
**System:** C1010 - Partitions

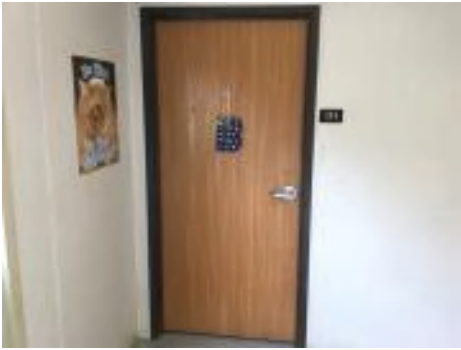
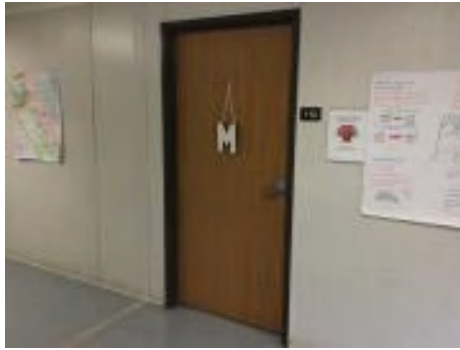
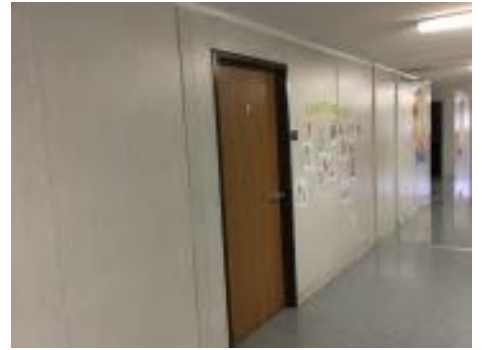
**System:** C1020 - Interior Doors

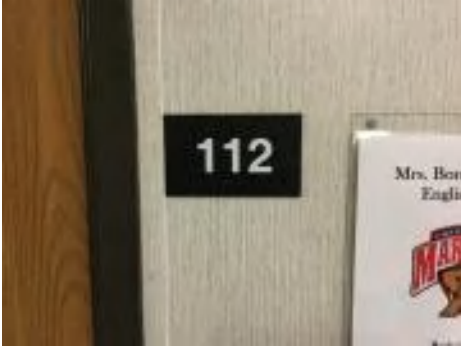
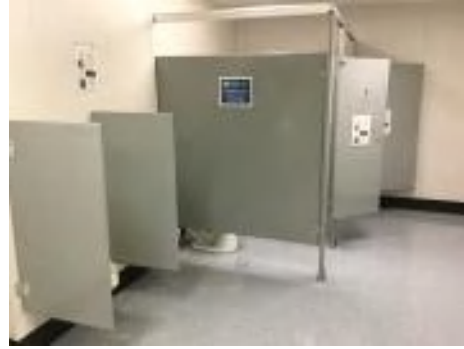
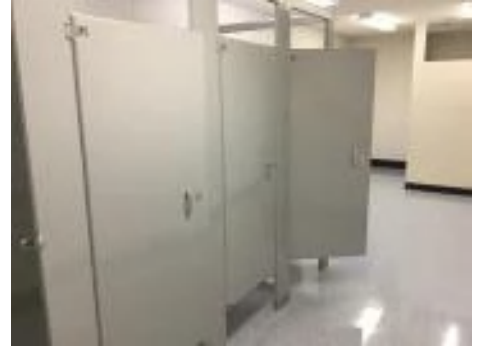
**System:** C1030 - Fittings

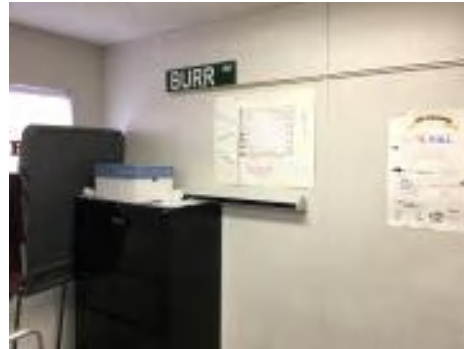
**System:** C3010 - Wall Finishes

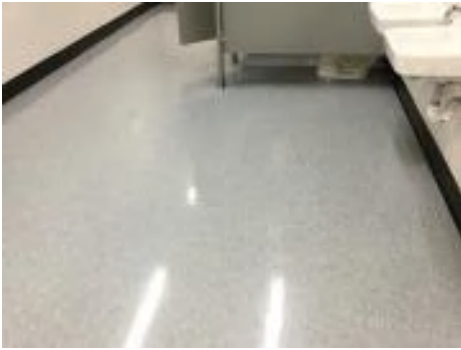
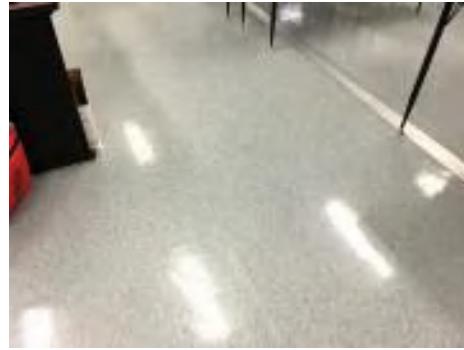
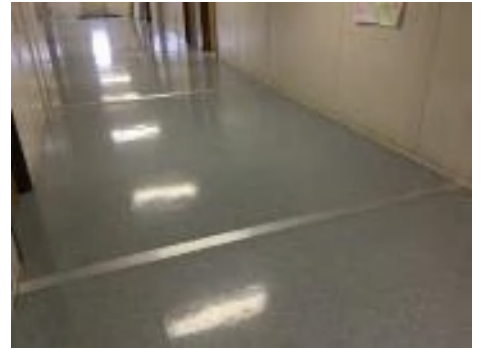
**System:** C3020 - Floor Finishes

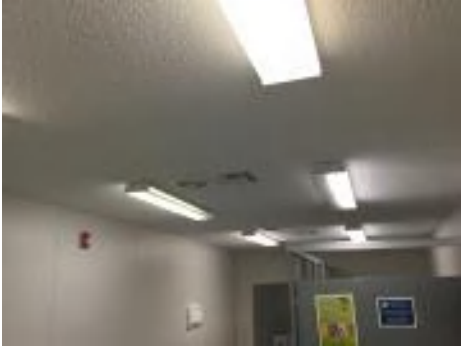
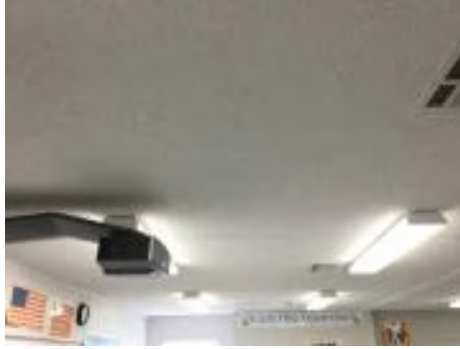
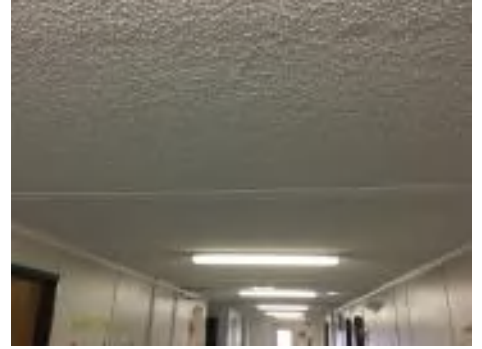
**System:** C3030 - Ceiling Finishes

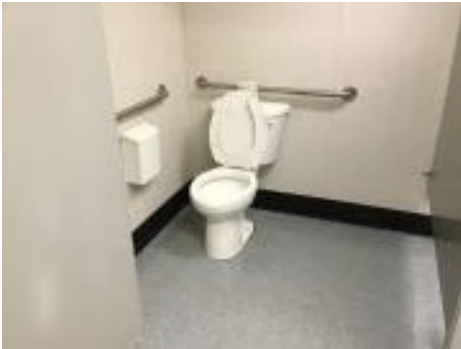
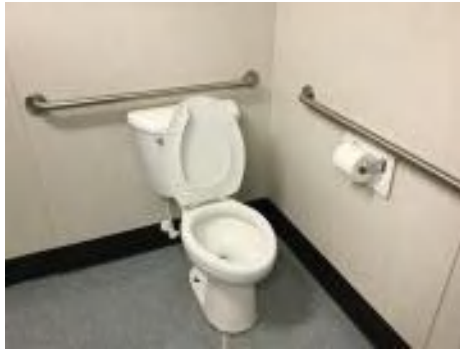
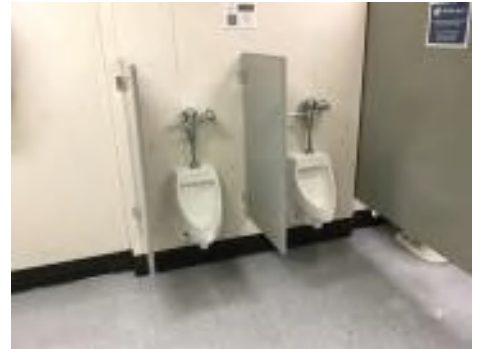
**System:** D2010 - Plumbing Fixtures

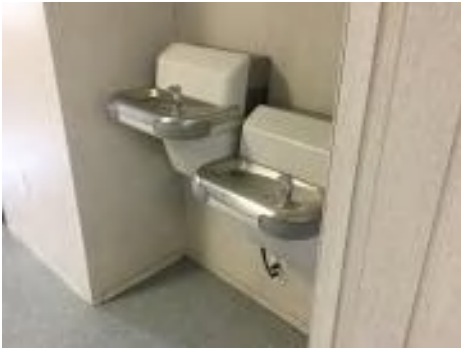
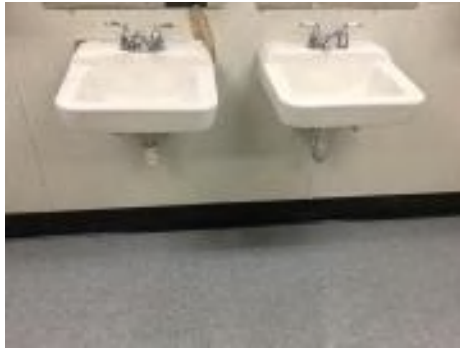
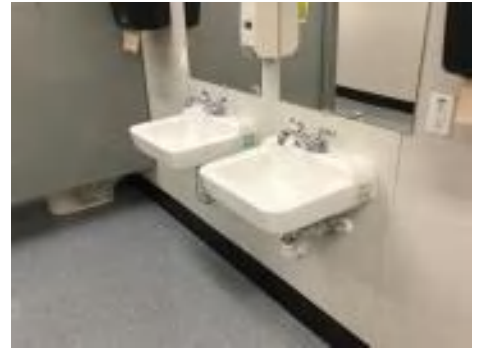
**System:** D2020 - Domestic Water Distribution

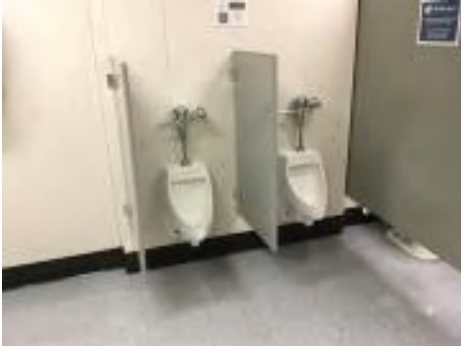
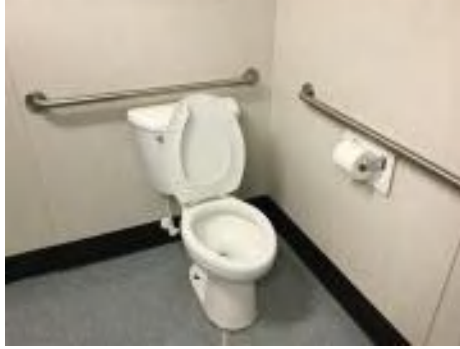
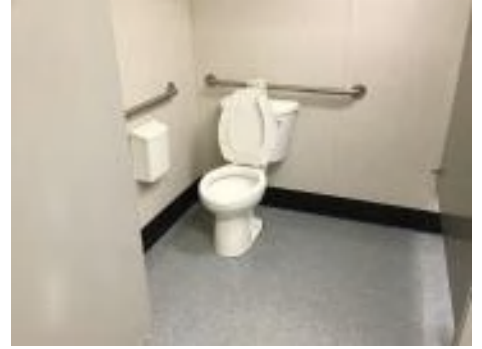
**System:** D2030 - Sanitary Waste

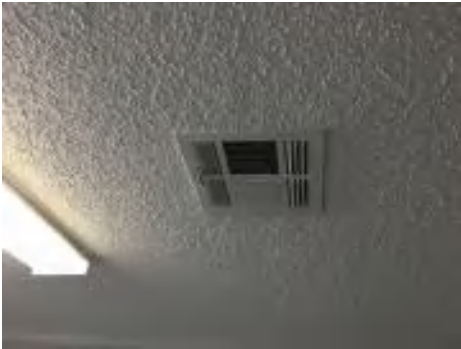
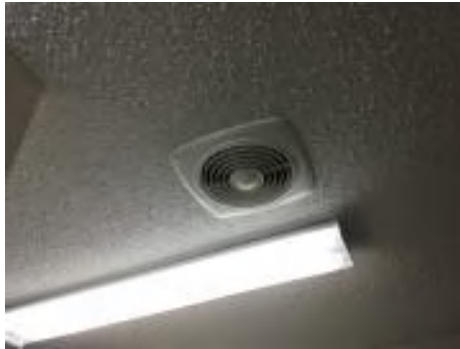
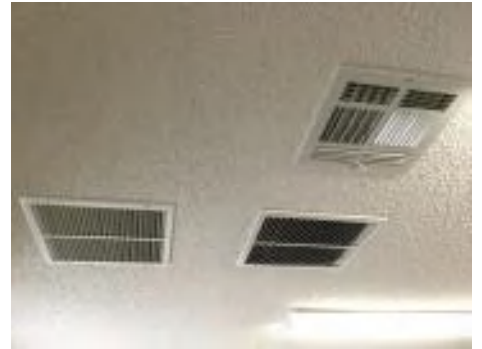
**System:** D3040 - Distribution Systems

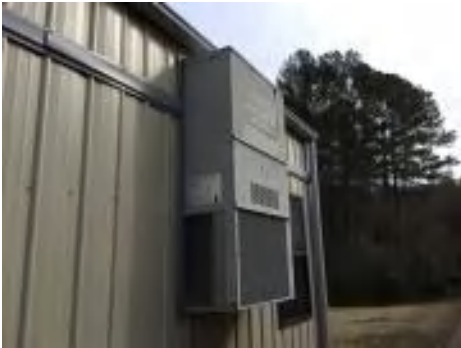
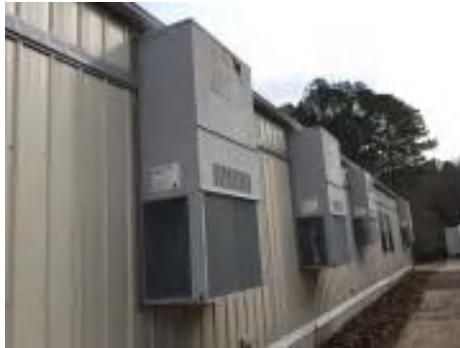
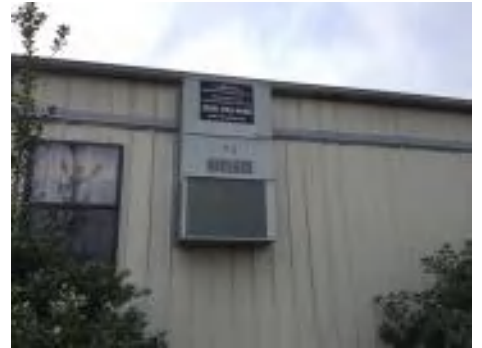
**System:** D3050 - Terminal & Package Units

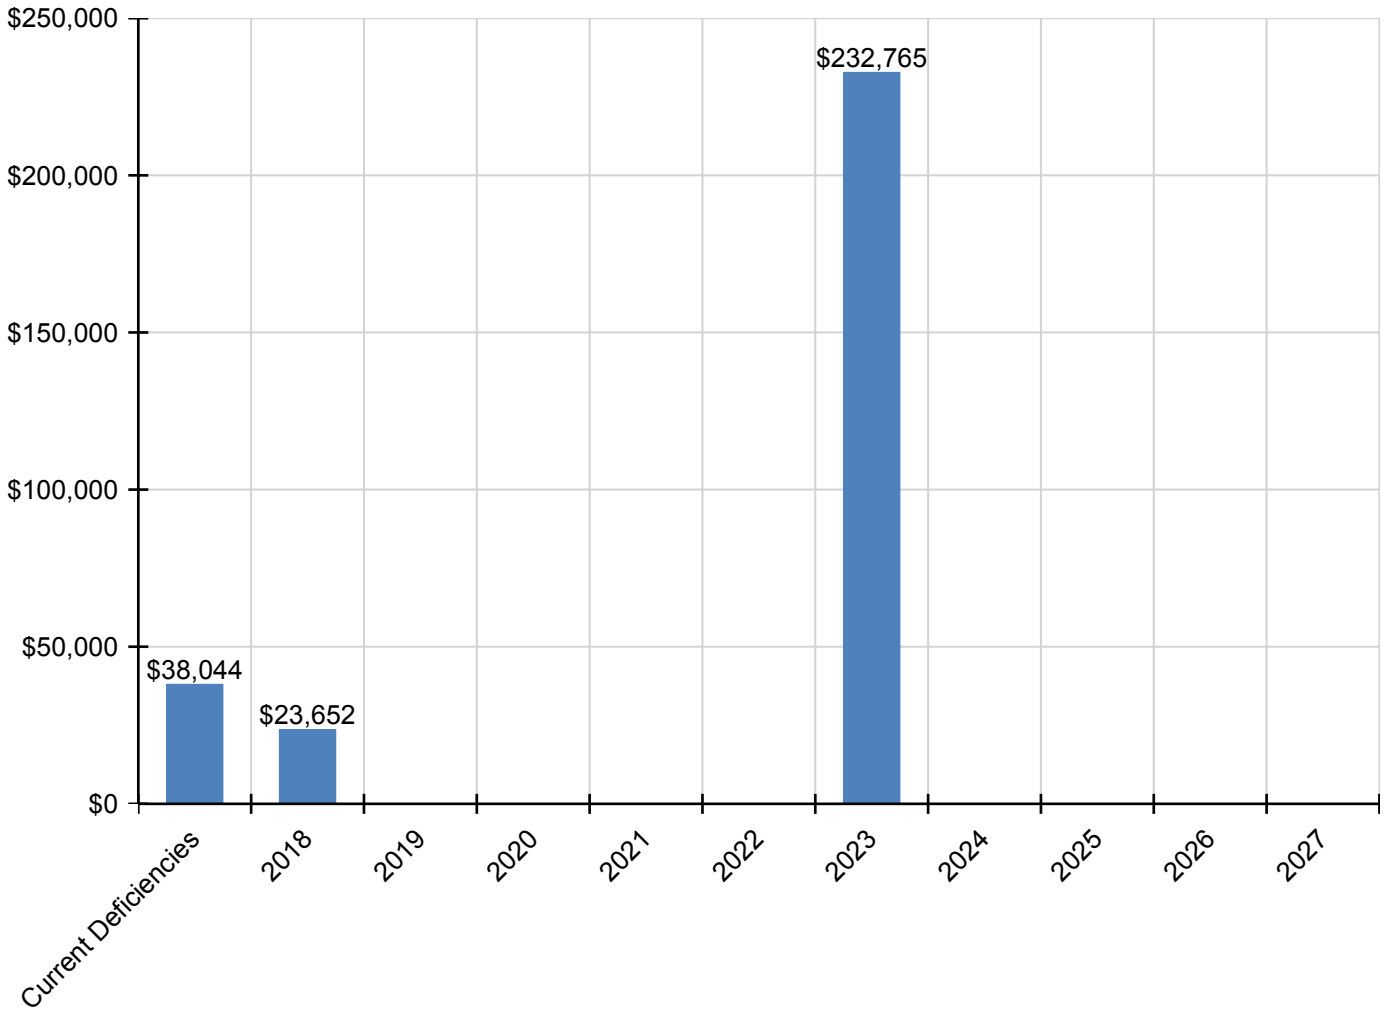
## Forecasted Capital Renewal Requirement

The following chart shows the current building deficiencies and forecasting capital renewal or sustainment requirements over the next ten years.

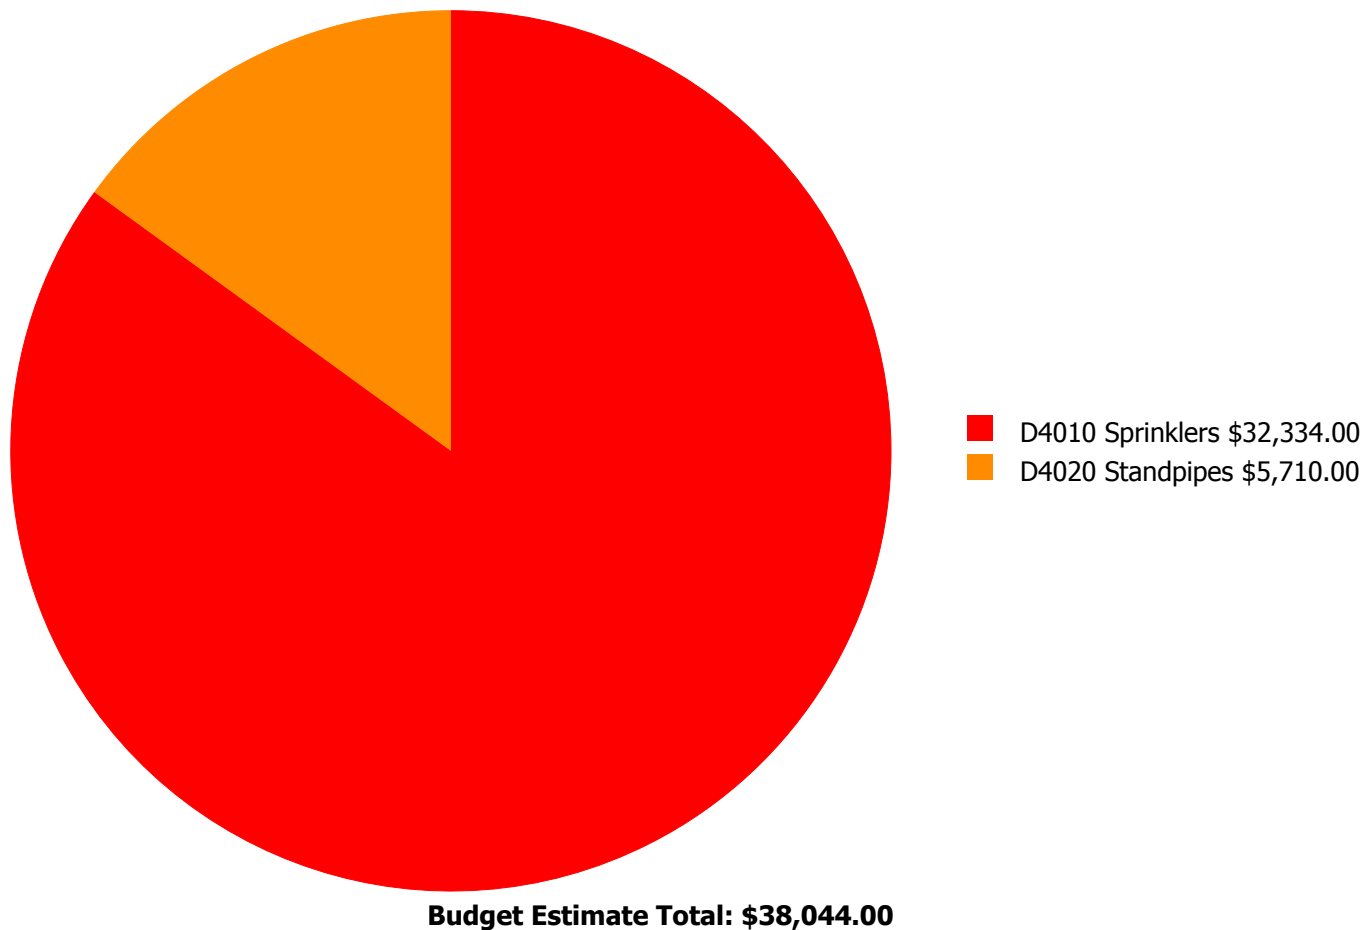
## Deficiency Summary by System

Current deficiencies included assemblies that have reached or exceeded their design life or components of the assemblies that are in need of repair. Assemblies that have reached their design life are identified as current deficiencies and assigned the distress 'Beyond Useful Life'. The following chart lists all current deficiencies associated with this facility.

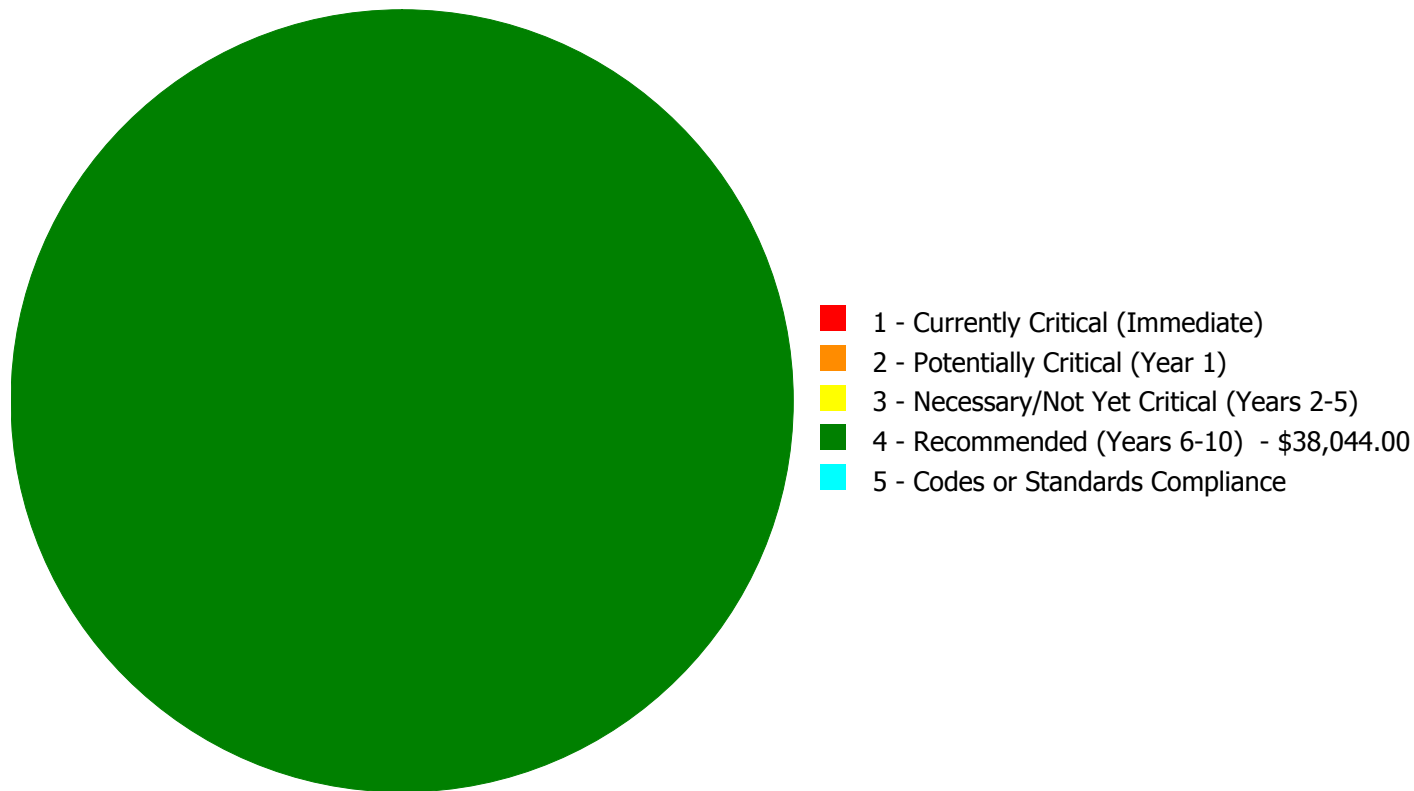
## Deficiency Summary by Priority

The following chart shows the total repair costs broken down by priority. Assessors assigned deficiencies within eCOMET to one of the following priority categories:

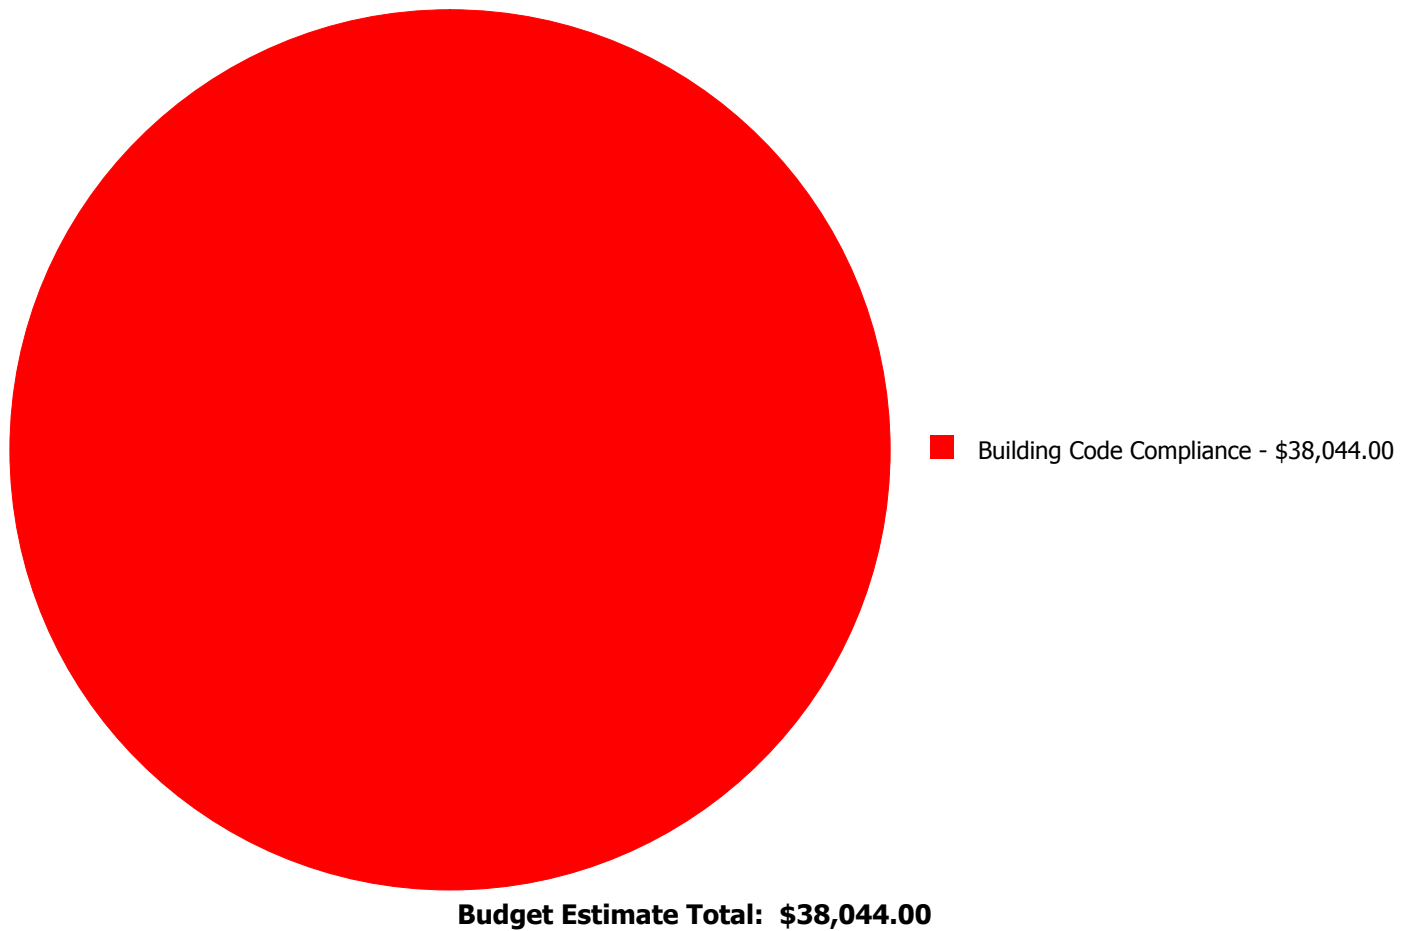
## Deficiency Summary by Category

The following chart shows the total repair costs broken down by deficiency categories. Assessors assigned deficiencies to one of the following categories:

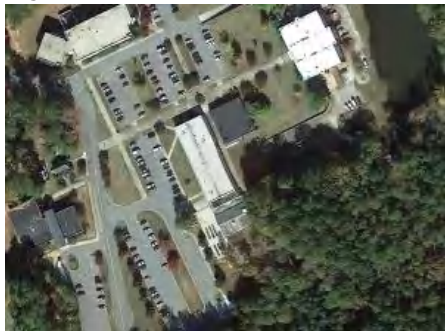
- 1). Aerial Image of Anson Co. Early College High School - Jan 19, 2017

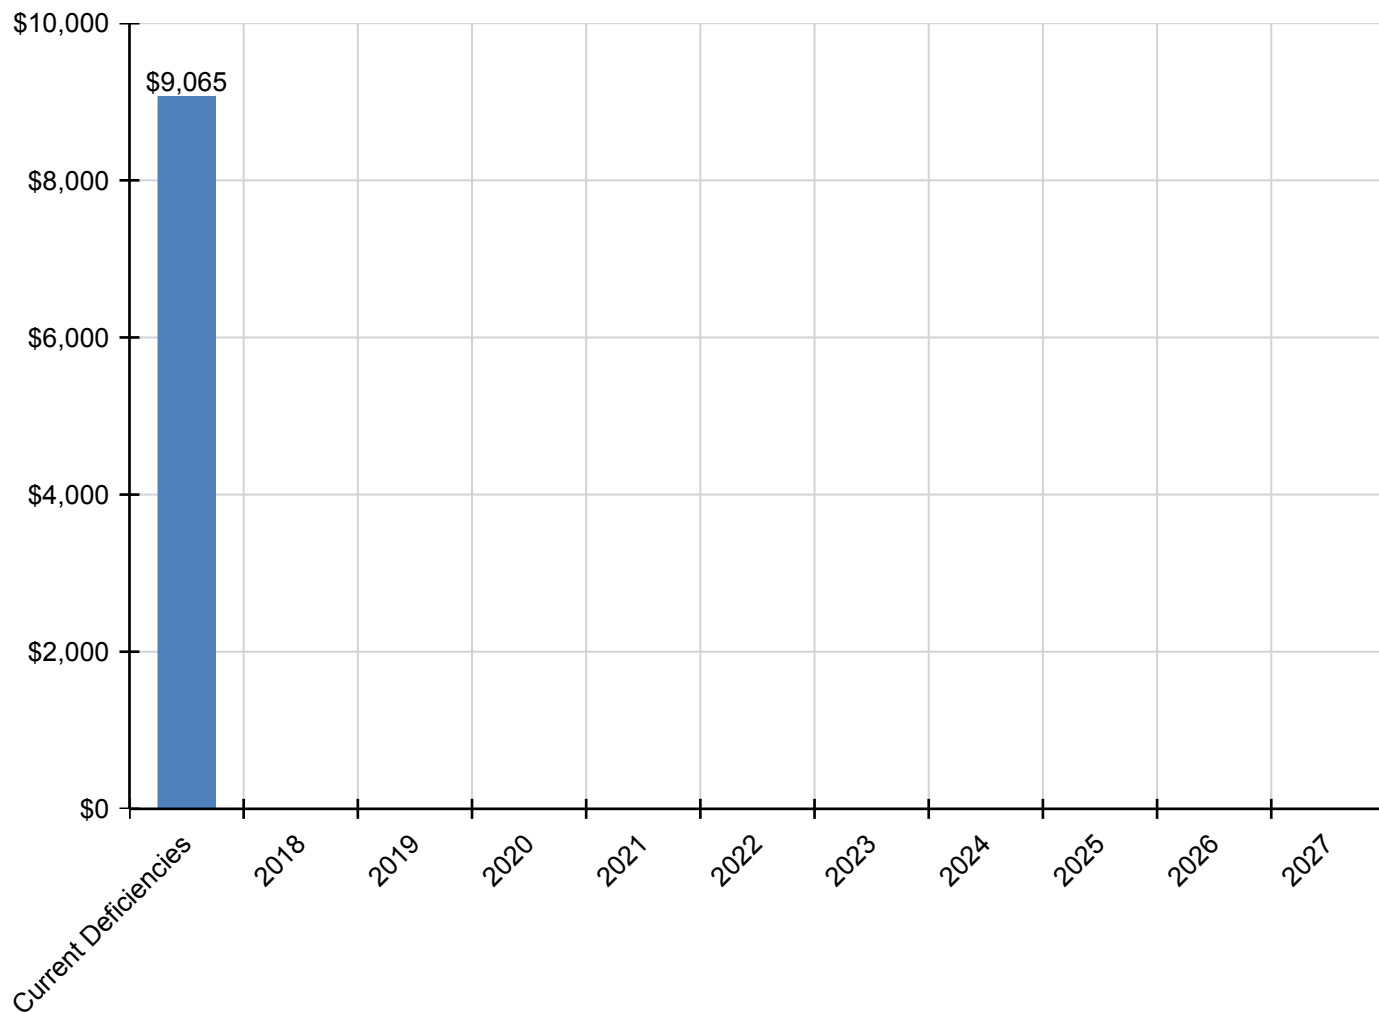
## Forecasted Capital Renewal Requirement

The following chart shows the current building deficiencies and forecasting capital renewal or sustainment requirements over the next ten years.
