# Anson Middle

## Campus Assessment Report

March 7, 2017

## Campus Assessment Report - 1966 Building, Cafe/Gym

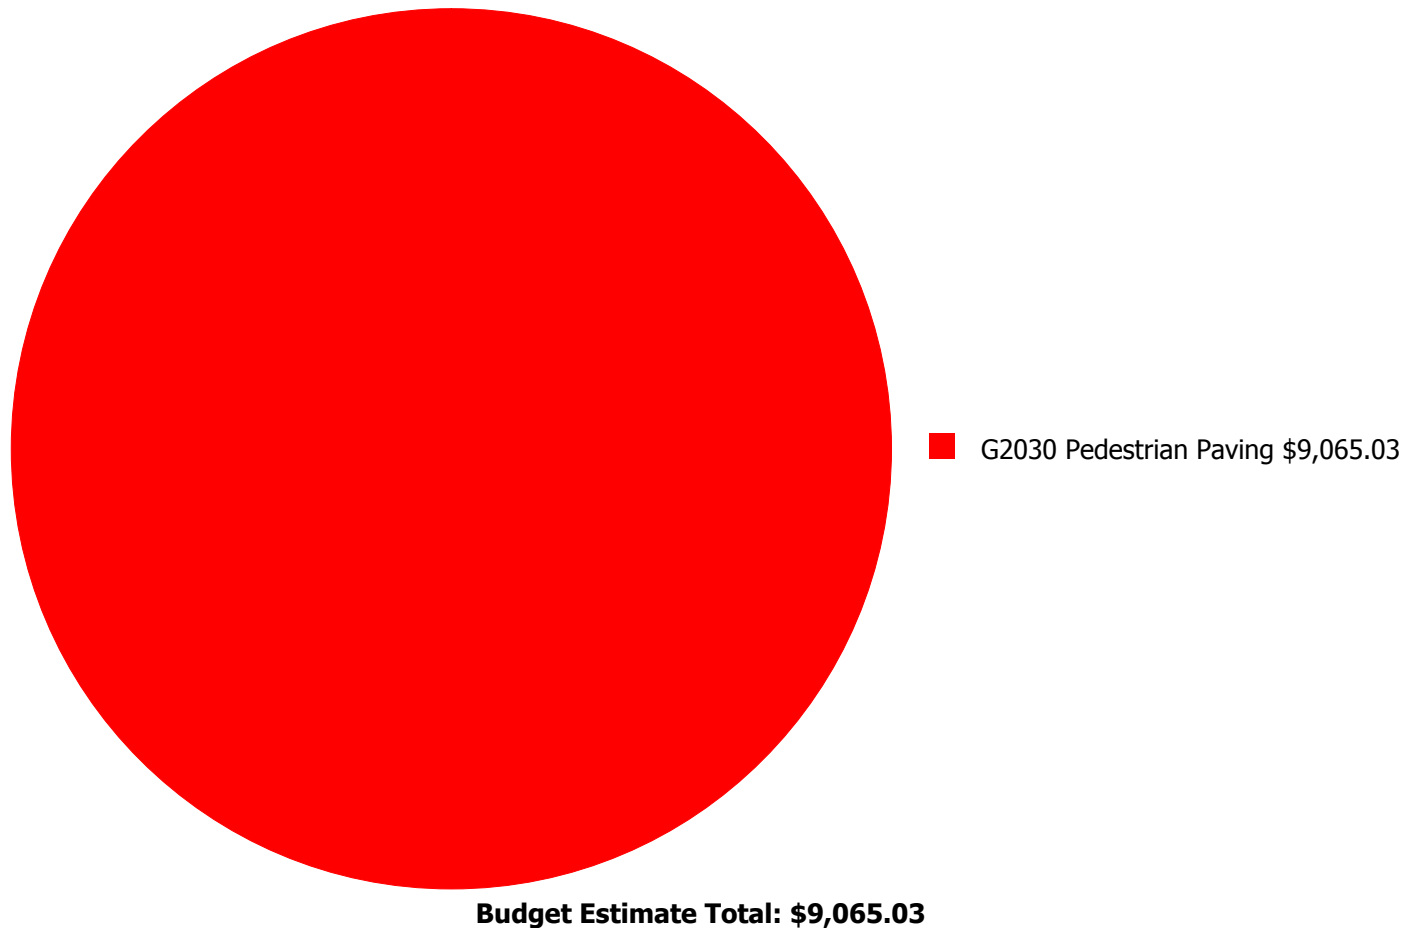
## Deficiency Summary by System

Current deficiencies included assemblies that have reached or exceeded their design life or components of the assemblies that are in need of repair. Assemblies that have reached their design life are identified as current deficiencies and assigned the distress 'Beyond Useful Life'. The following chart lists all current deficiencies associated with this facility.

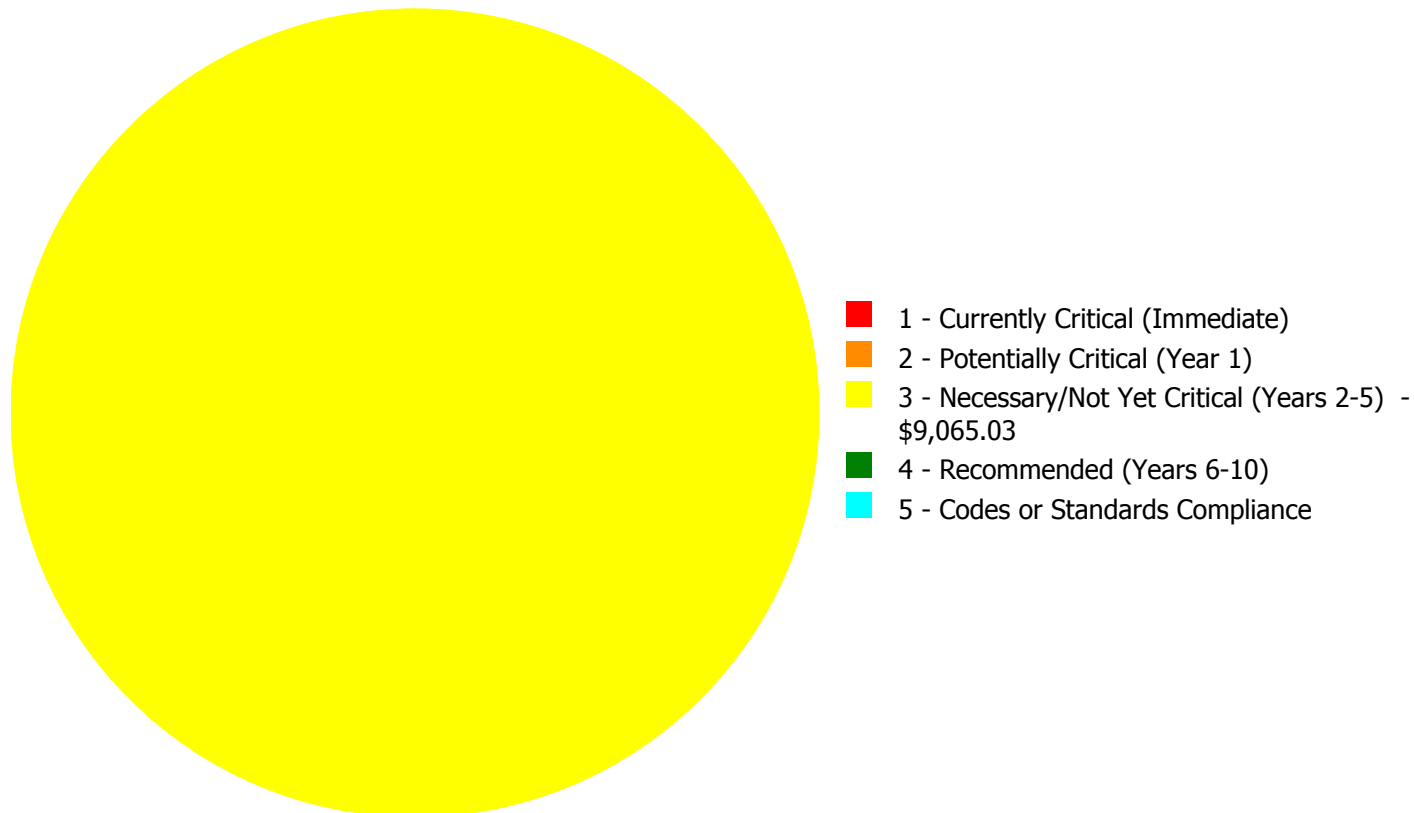
## Deficiency Summary by Priority

The following chart shows the total repair costs broken down by priority. Assessors assigned deficiencies within eCOMET to one of the following priority categories:

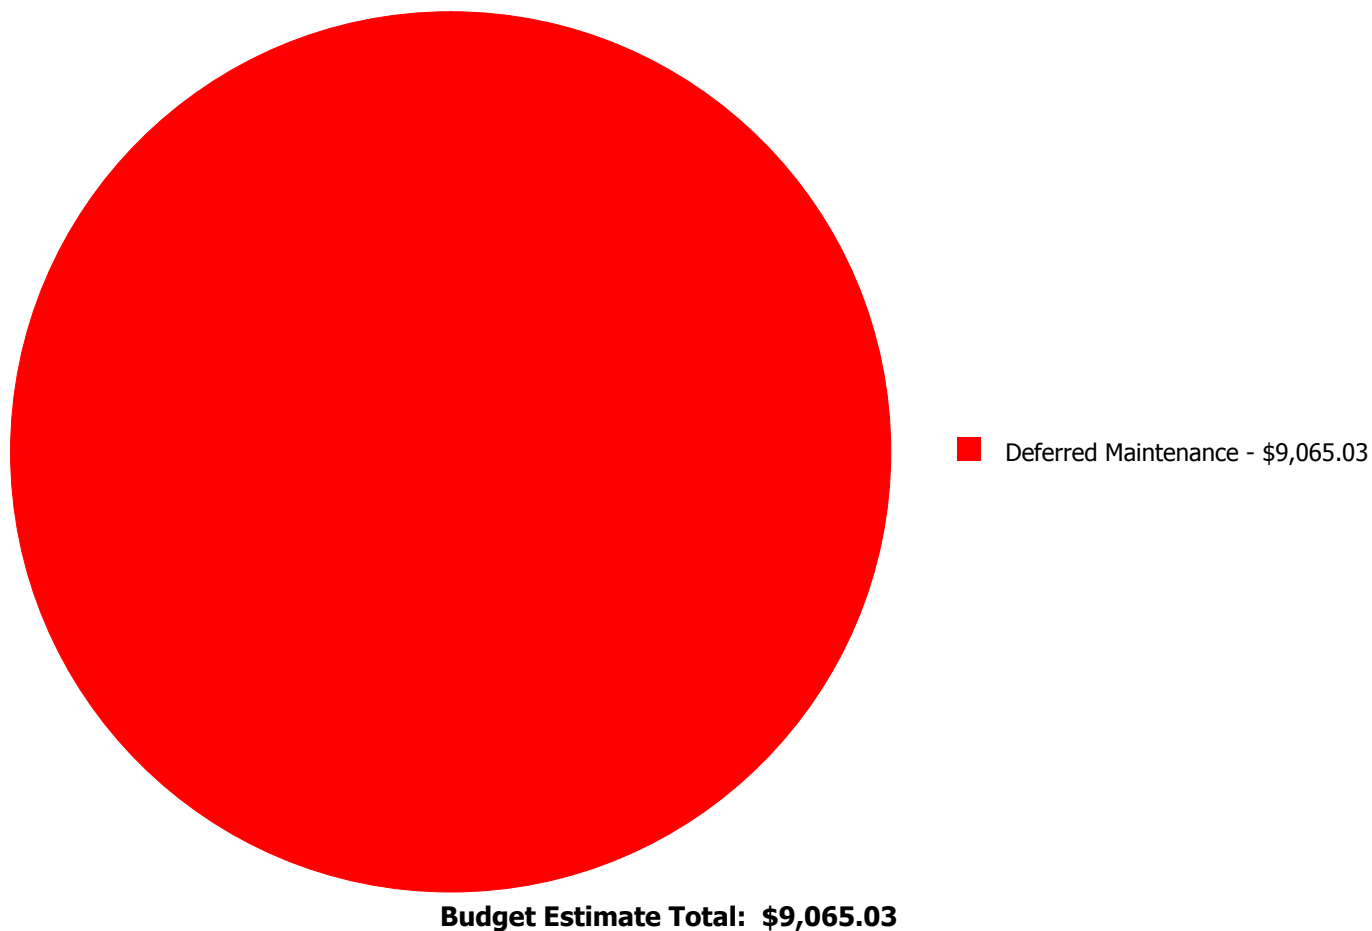
## Deficiency Summary by Category

The following chart shows the total repair costs broken down by deficiency categories. Assessors assigned deficiencies to one of the following categories:

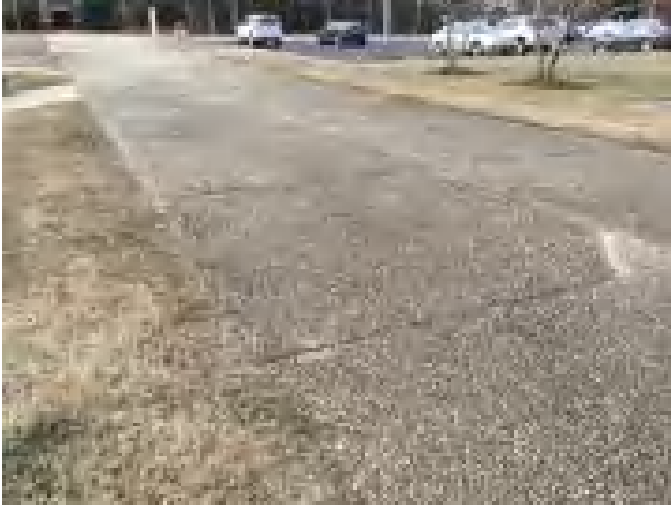
#### **System: G2030 - Pedestrian Paving**

**Location:** Site  
**Distress:** Failing  
**Category:** Deferred Maintenance  
**Priority:** 3 - Necessary/Not Yet Critical (Years 2-5)  
**Correction:** Remove and replace asphalt sidewalk, 4' wide  
**Qty:** 400.00  
**Unit of Measure:** L.F.  
**Estimate:** \$9,065.03  
**Assessor Name:** Eduardo Lopez  
**Date Created:** 01/18/2017

**Notes:** The pedestrian paving is in poor condition and it should be repaved.

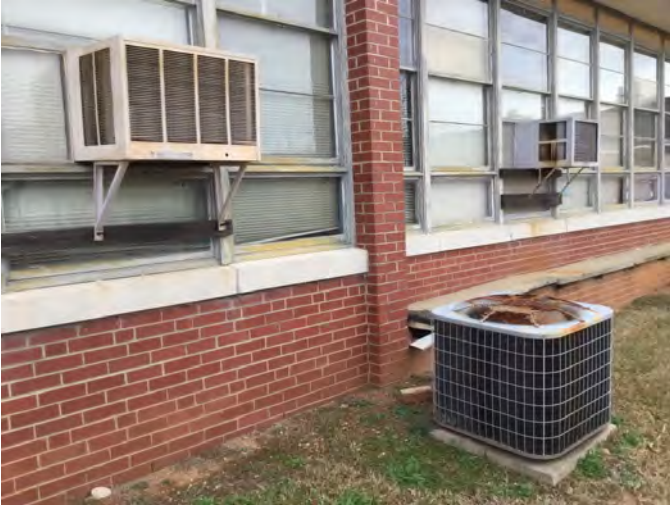
#### System: B2020 - Exterior Windows

**Location:** Exterior Walls  
**Distress:** Beyond Service Life  
**Category:** Deferred Maintenance  
**Priority:** 3 - Necessary/Not Yet Critical (Years 2-5)  
**Correction:** Renew System  
**Qty:** 12,158.00  
**Unit of Measure:** S.F.  
**Estimate:** \$206,893.00  
**Assessor Name:** Eduardo Lopez  
**Date Created:** 01/04/2017

**Notes:** The exterior windows are aged, rusted, not energy efficient and should be replaced.

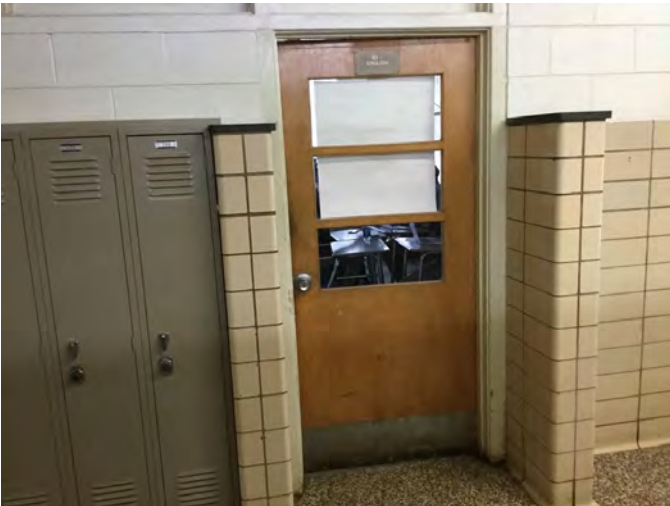
#### System: C1020 - Interior Doors

**Location:** Throughout the Building  
**Distress:** Beyond Service Life  
**Category:** Deferred Maintenance  
**Priority:** 3 - Necessary/Not Yet Critical (Years 2-5)  
**Correction:** Renew System  
**Qty:** 12,158.00  
**Unit of Measure:** S.F.  
**Estimate:** \$39,319.00  
**Assessor Name:** Eduardo Lopez  
**Date Created:** 01/04/2017

**Notes:** The interior doors are aged, failing, most hardware is not ADA or code compliant and should be replaced.

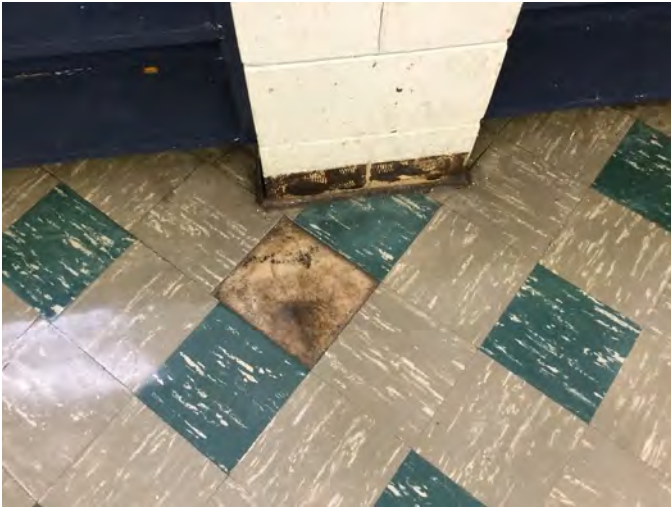
**System: C3020 - Floor Finishes**

**Location:** Throughout the Building  
**Distress:** Beyond Service Life  
**Category:** Deferred Maintenance  
**Priority:** 3 - Necessary/Not Yet Critical (Years 2-5)  
**Correction:** Renew System  
**Qty:** 12,158.00  
**Unit of Measure:** S.F.  
**Estimate:** \$177,203.00  
**Assessor Name:** Eduardo Lopez  
**Date Created:** 01/04/2017

**Notes:** The original flooring is in poor conditions and should be replaced.

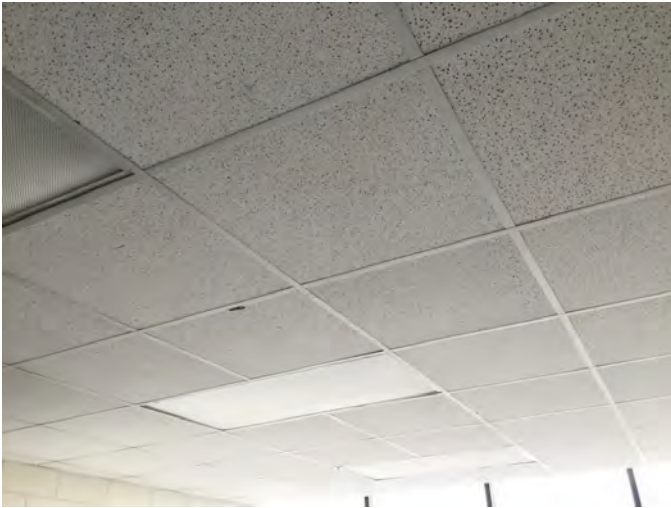
**System: C3030 - Ceiling Finishes**

**Location:** Throughout the Building  
**Distress:** Beyond Service Life  
**Category:** Deferred Maintenance  
**Priority:** 3 - Necessary/Not Yet Critical (Years 2-5)  
**Correction:** Renew System  
**Qty:** 12,158.00  
**Unit of Measure:** S.F.  
**Estimate:** \$171,051.00  
**Assessor Name:** Eduardo Lopez  
**Date Created:** 01/04/2017

**Notes:** The original ceiling finishes are aged, failing and should be replaced.

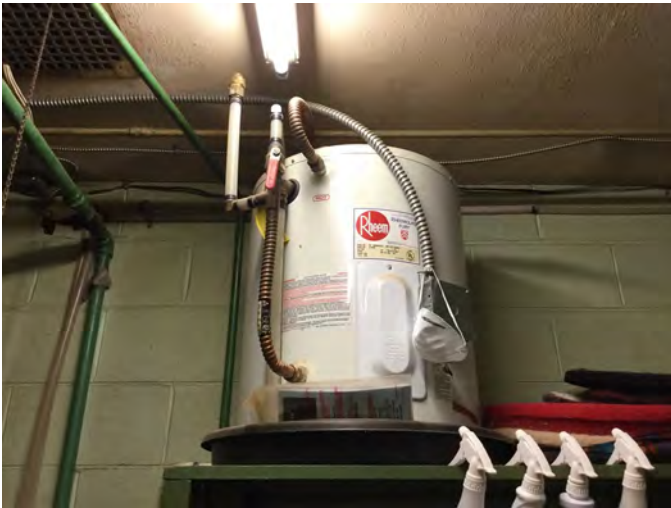
**System: D2020 - Domestic Water Distribution**

**Notes:** The domestic water distribution system is aged and should be replaced.

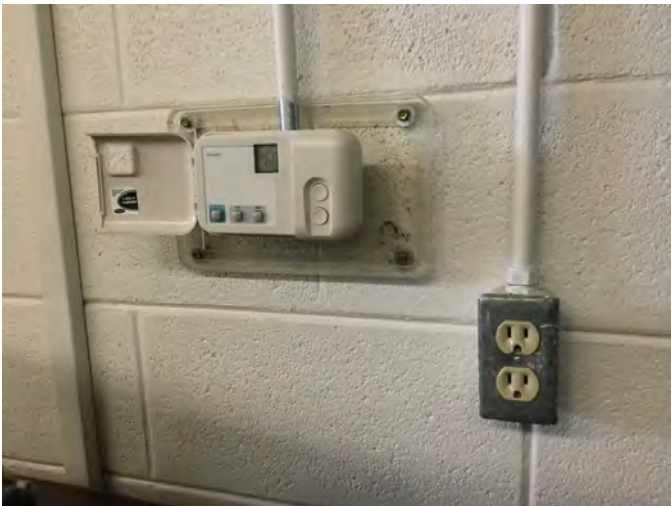
**System: D3060 - Controls & Instrumentation**

**Notes:** The controls and instrumentation system is in marginal condition and should be schedule for replacement.

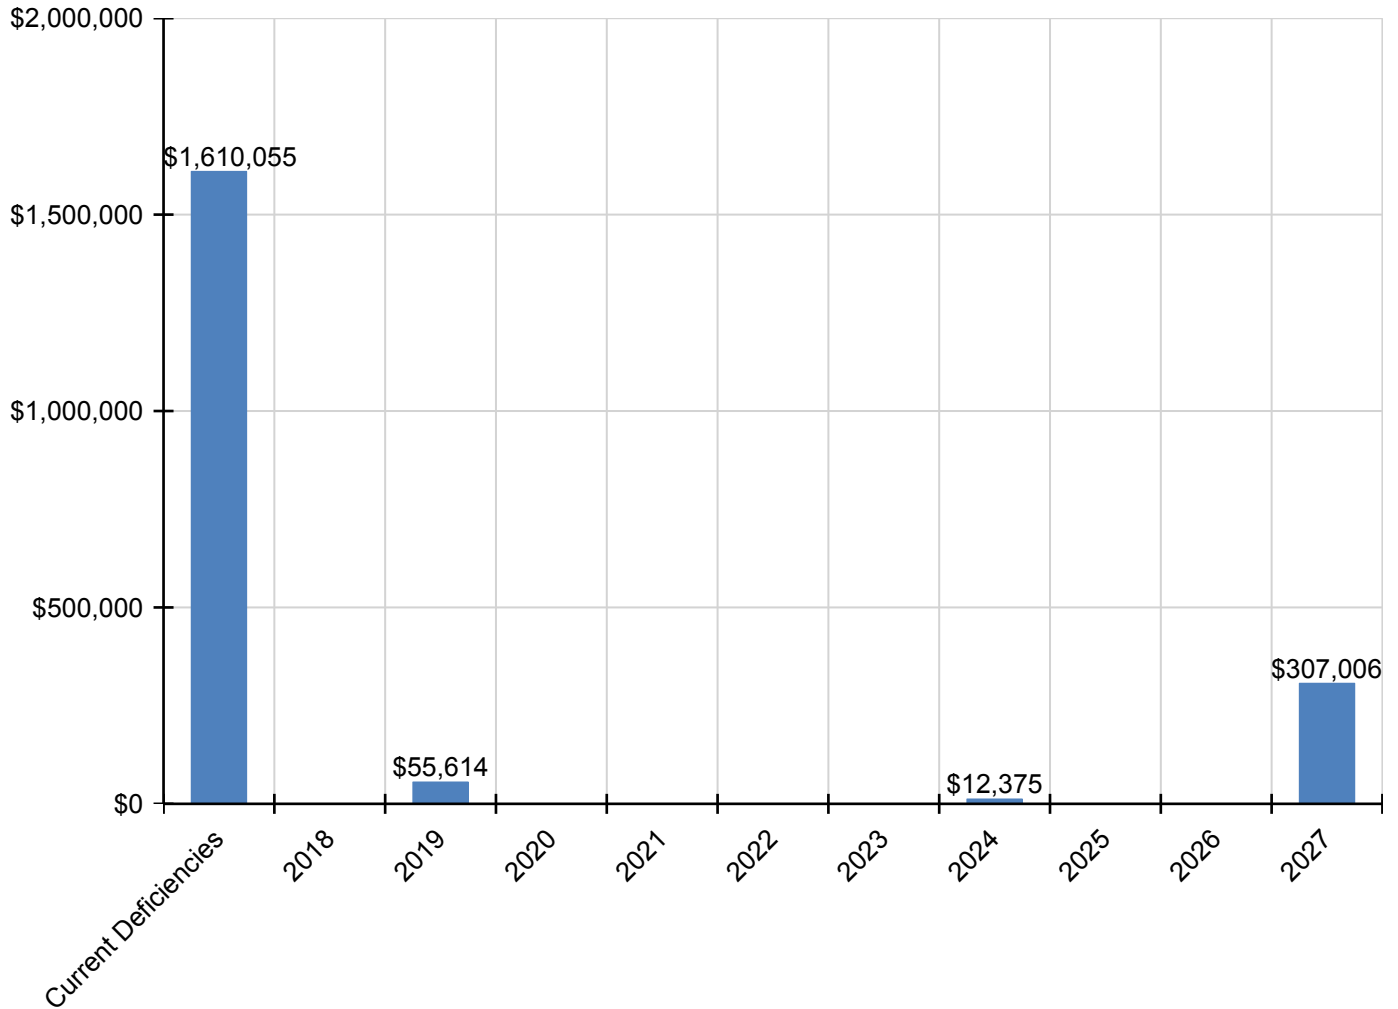
## Forecasted Capital Renewal Requirement

The following chart shows the current building deficiencies and forecasting capital renewal or sustainment requirements over the next ten years.

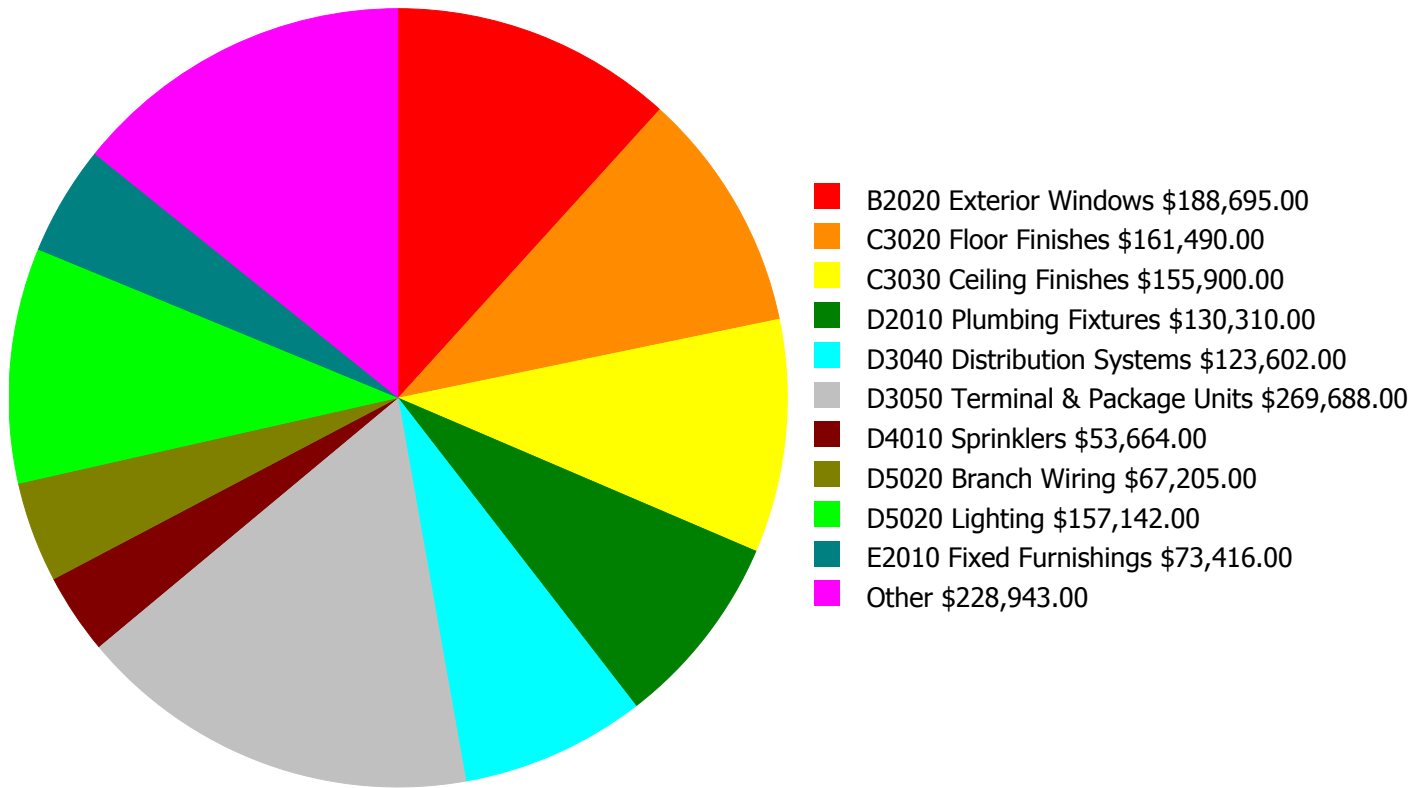
## Deficiency Summary by System

Current deficiencies included assemblies that have reached or exceeded their design life or components of the assemblies that are in need of repair. Assemblies that have reached their design life are identified as current deficiencies and assigned the distress 'Beyond Useful Life'. The following chart lists all current deficiencies associated with this facility.

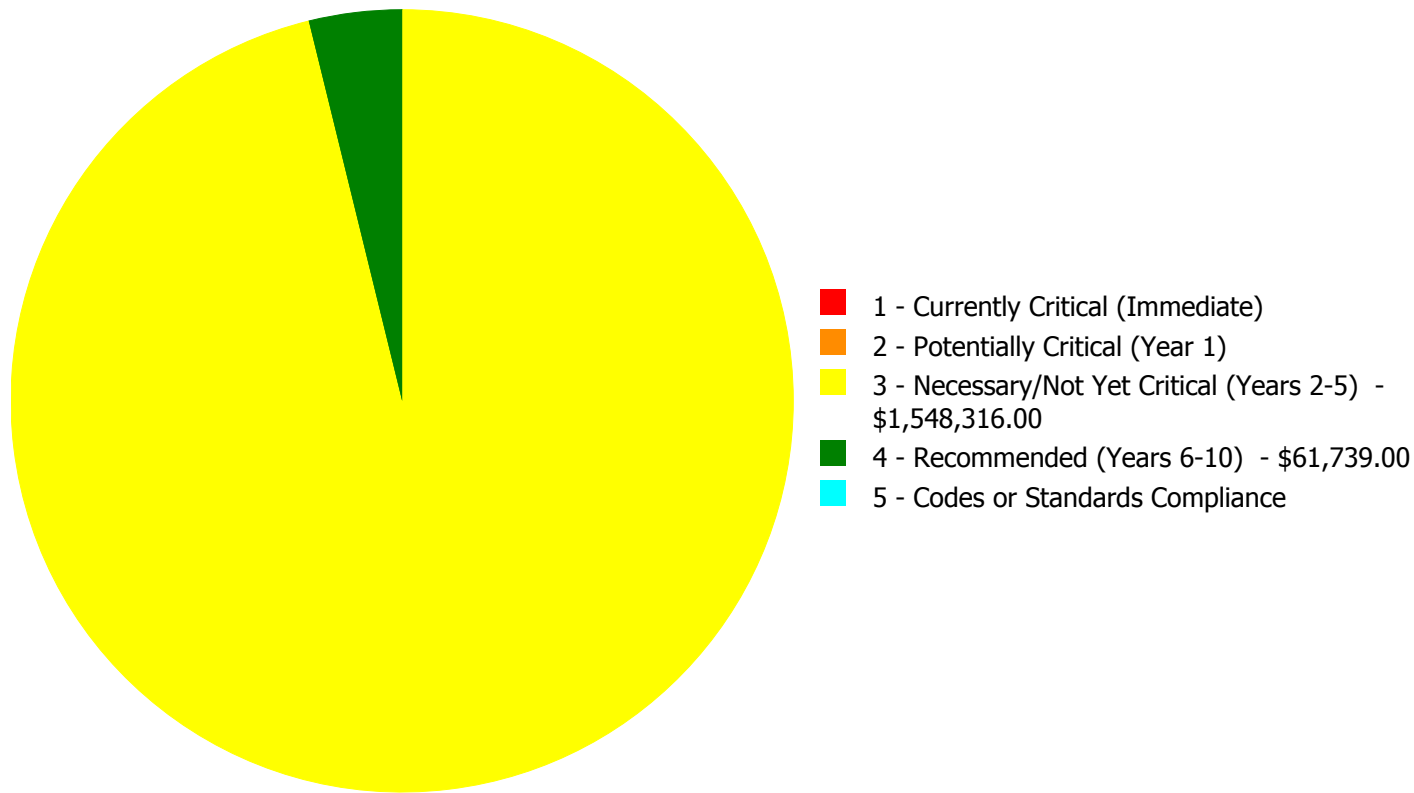
### Deficiency Summary by Priority

The following chart shows the total repair costs broken down by priority. Assessors assigned deficiencies within eCOMET to one of the following priority categories:

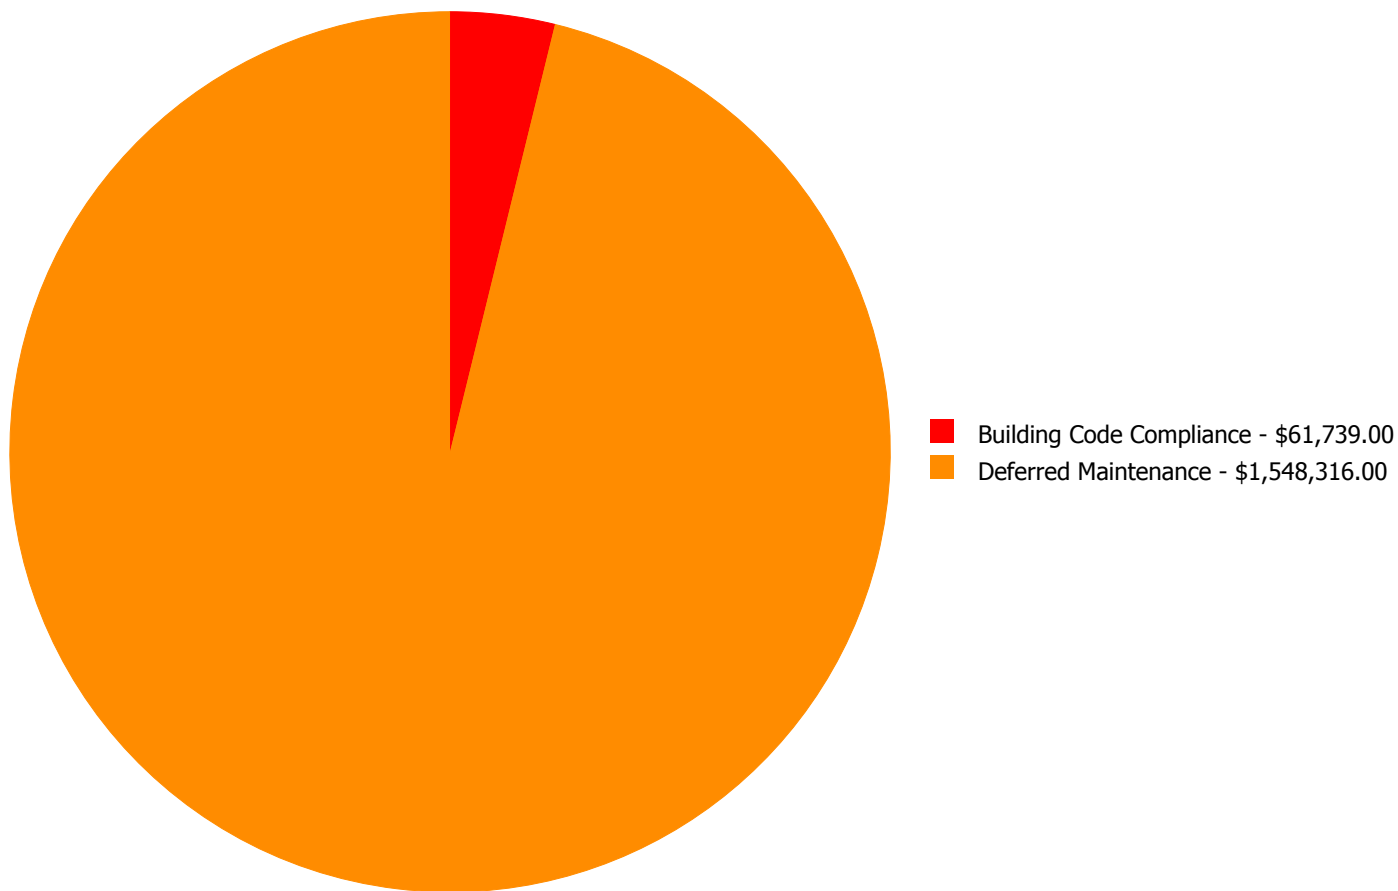
### Deficiency Summary by Category

The following chart shows the total repair costs broken down by deficiency categories. Assessors assigned deficiencies to one of the following categories:

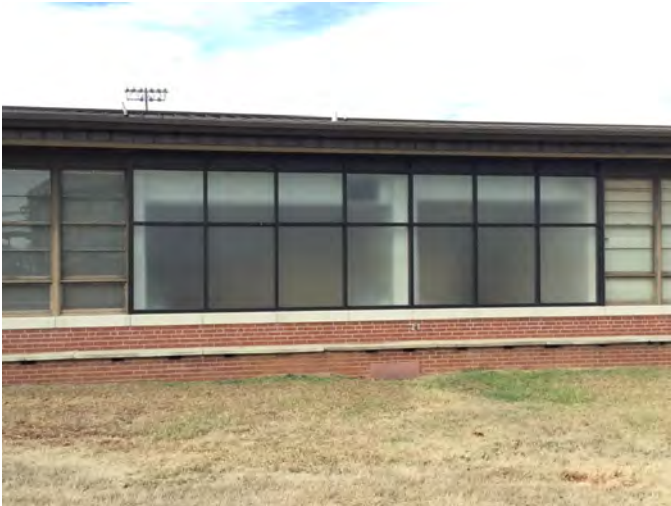
#### System: B2020 - Exterior Windows

**Location:** Exterior Walls  
**Distress:** Beyond Service Life  
**Category:** Deferred Maintenance  
**Priority:** 3 - Necessary/Not Yet Critical (Years 2-5)  
**Correction:** Renew System  
**Qty:** 11,293.00  
**Unit of Measure:** S.F.  
**Estimate:** \$188,695.00  
**Assessor Name:** Eduardo Lopez  
**Date Created:** 01/04/2017

**Notes:** The exterior windows are aged, rusted, not energy efficient and should be replaced.

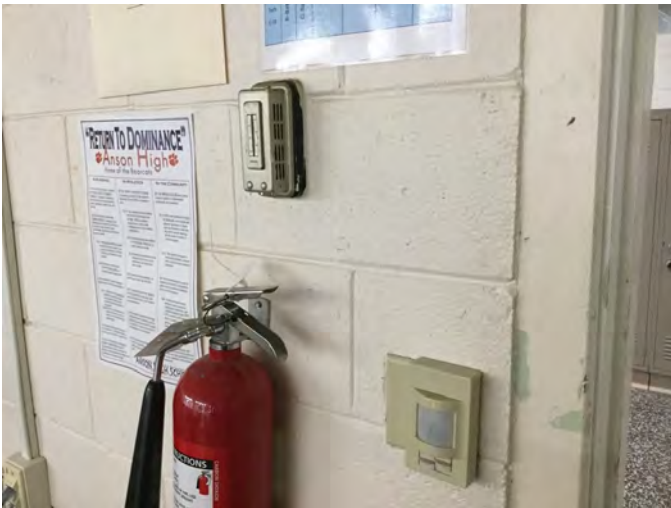
**System: D3060 - Controls & Instrumentation**

**Location:** Throughout the Building  
**Distress:** Beyond Service Life  
**Category:** Deferred Maintenance  
**Priority:** 3 - Necessary/Not Yet Critical (Years 2-5)  
**Correction:** Renew System  
**Qty:** 11,293.00  
**Unit of Measure:** S.F.  
**Estimate:** \$39,130.00  
**Assessor Name:** Eduardo Lopez  
**Date Created:** 01/04/2017

**Notes:** The controls and instrumentation system is in marginal condition and should be schedule for replacement.

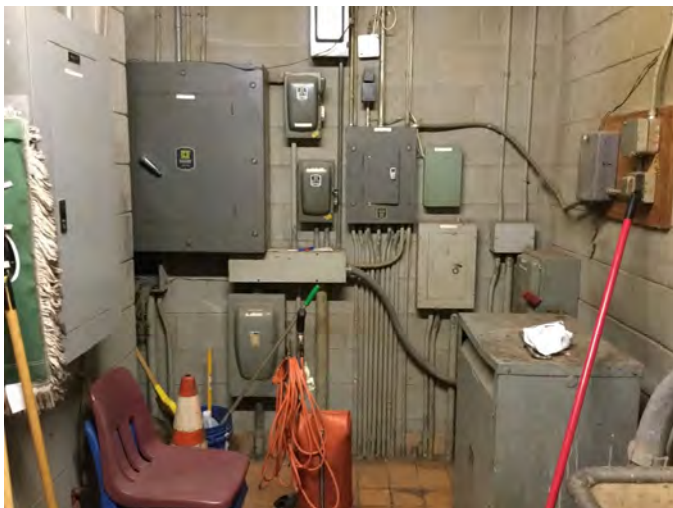
**System: D5010 - Electrical Service/Distribution**

**Location:** Throughout the Building  
**Distress:** Beyond Service Life  
**Category:** Deferred Maintenance  
**Priority:** 3 - Necessary/Not Yet Critical (Years 2-5)  
**Correction:** Renew System  
**Qty:** 11,293.00  
**Unit of Measure:** S.F.  
**Estimate:** \$23,602.00  
**Assessor Name:** Eduardo Lopez  
**Date Created:** 01/04/2017

**Notes:** The original electrical service is operating but is in poor condition and should be replaced.

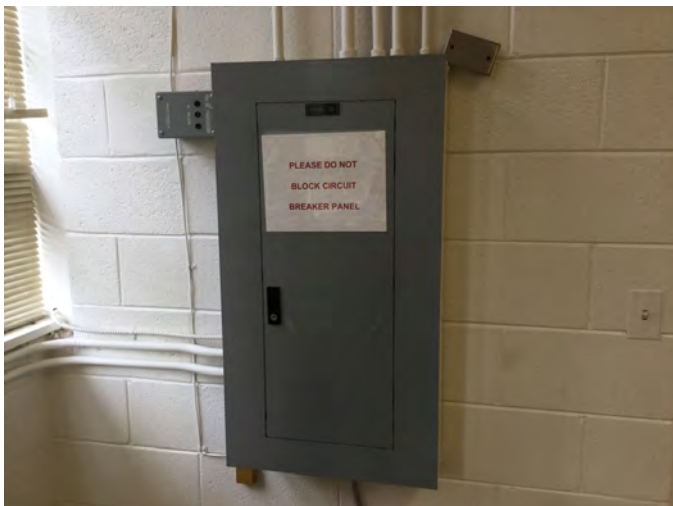
**System: D5020 - Branch Wiring**

**Location:** Throughout the Building  
**Distress:** Beyond Service Life  
**Category:** Deferred Maintenance  
**Priority:** 3 - Necessary/Not Yet Critical (Years 2-5)  
**Correction:** Renew System  
**Qty:** 11,293.00  
**Unit of Measure:** S.F.  
**Estimate:** \$67,205.00  
**Assessor Name:** Eduardo Lopez  
**Date Created:** 01/04/2017

**Notes:** The original branch wiring system is operating but is aged, in marginal condition, and should be replaced.

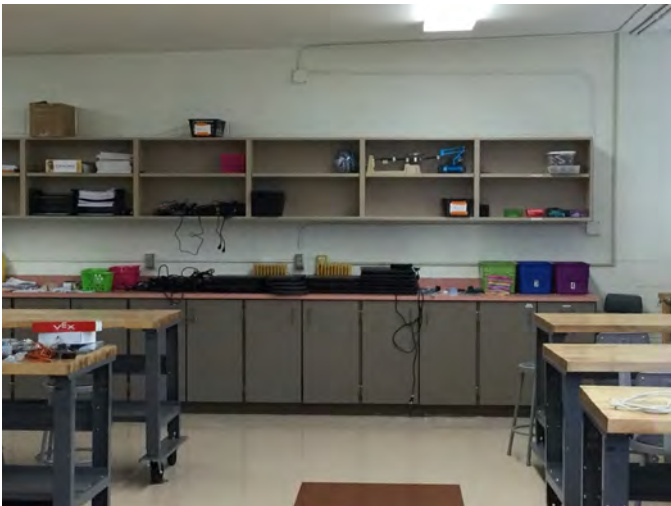
**System: E2010 - Fixed Furnishings**

**Location:** Throughout the Building  
**Distress:** Beyond Service Life  
**Category:** Deferred Maintenance  
**Priority:** 3 - Necessary/Not Yet Critical (Years 2-5)  
**Correction:** Renew System  
**Qty:** 11,293.00  
**Unit of Measure:** S.F.  
**Estimate:** \$73,416.00  
**Assessor Name:** Eduardo Lopez  
**Date Created:** 01/04/2017

**Notes:** The fixed furnishings are aged, in marginal condition, and should be replaced.

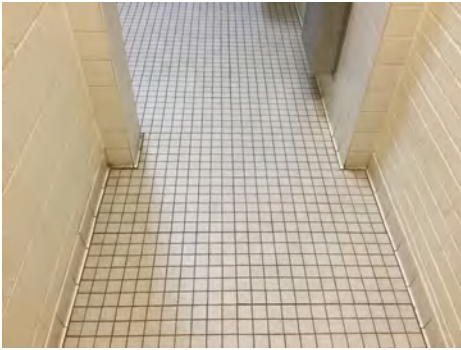
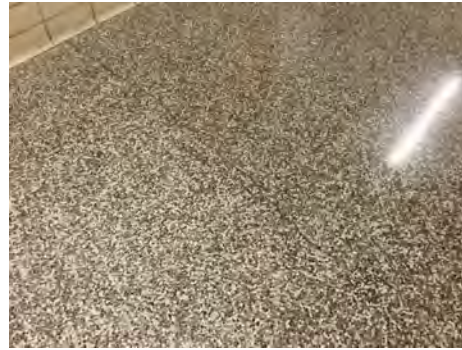
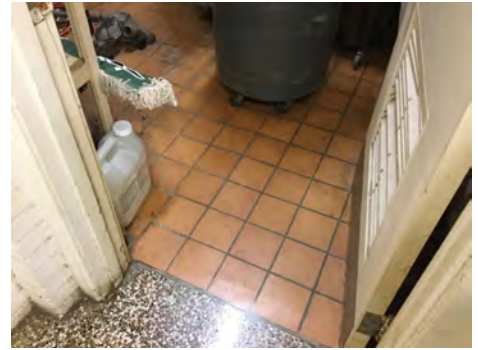
**System:** C3020 - Floor Finishes

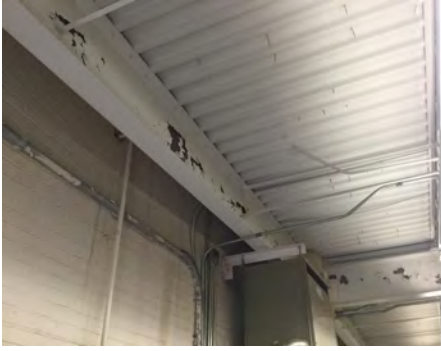
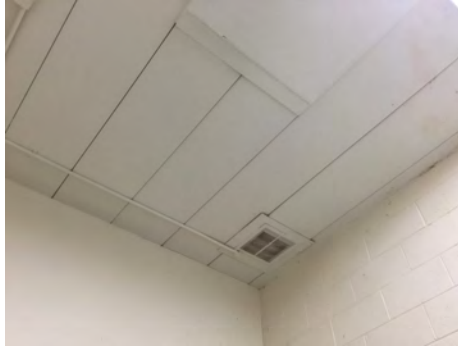
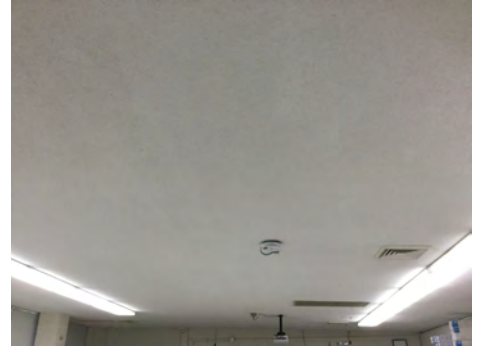
**System:** C3030 - Ceiling Finishes

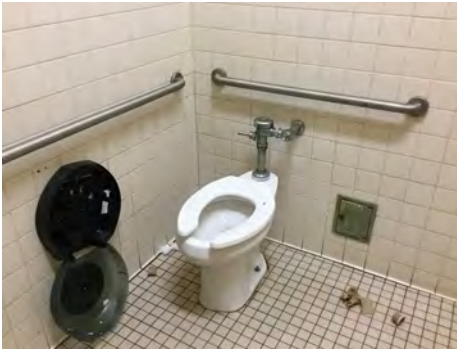
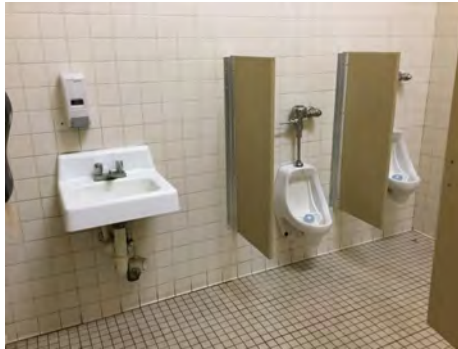
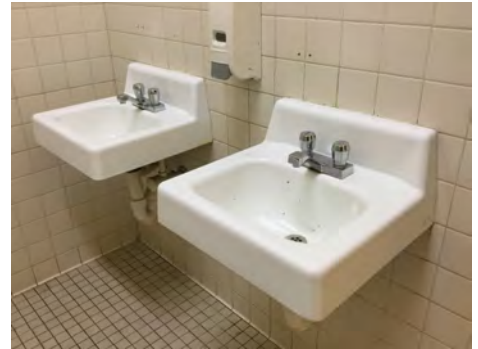
**System:** D2010 - Plumbing Fixtures

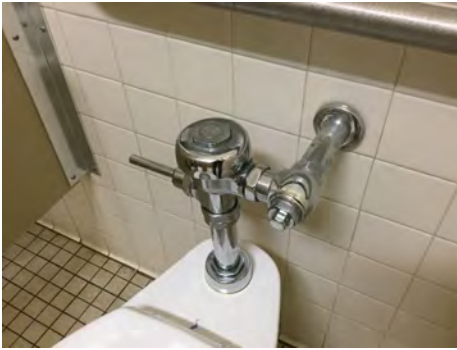
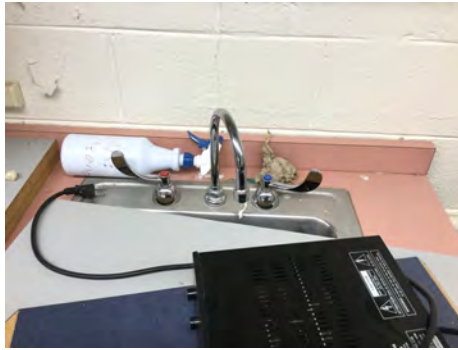
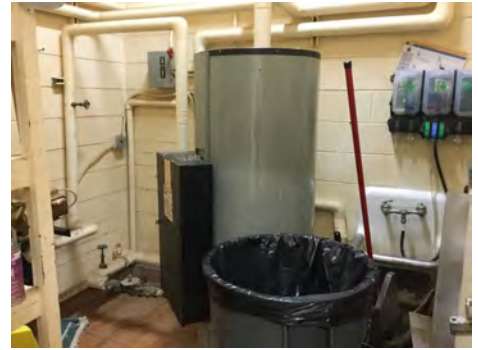
**System:** D2020 - Domestic Water Distribution

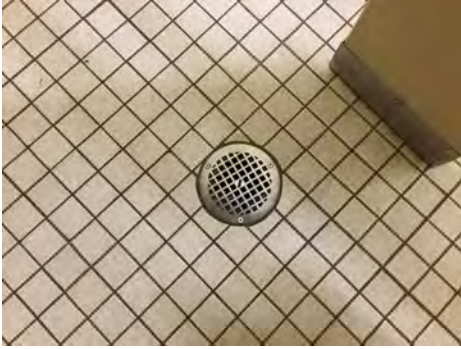
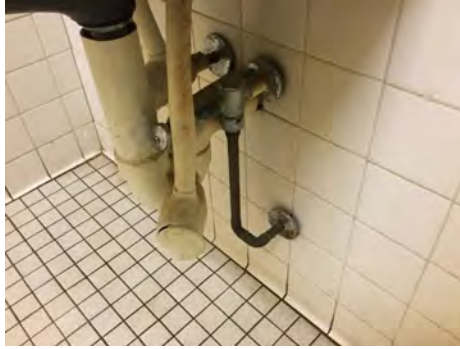
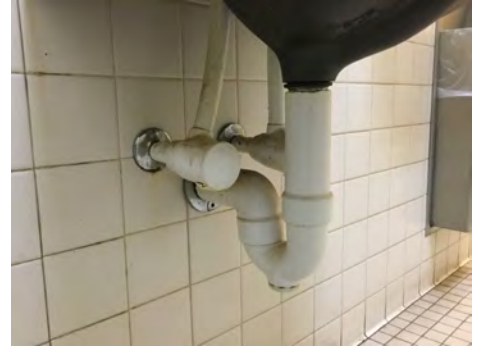
**System:** D2030 - Sanitary Waste

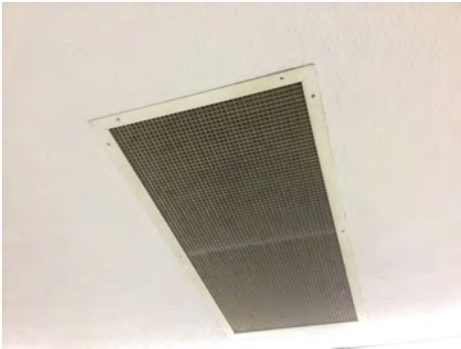
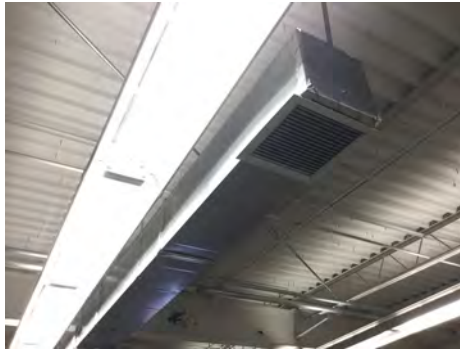
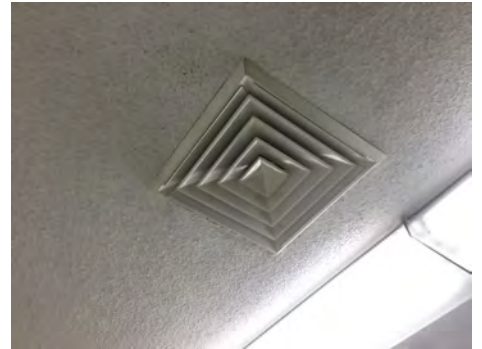
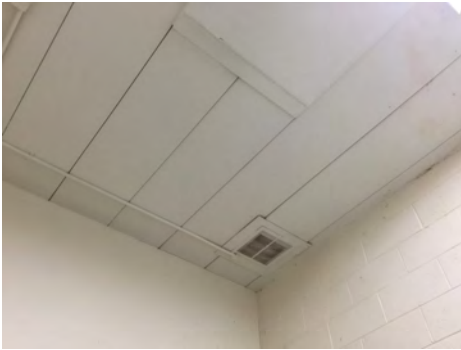
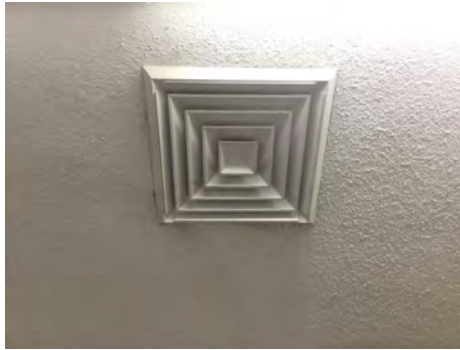
**System:** D3040 - Distribution Systems

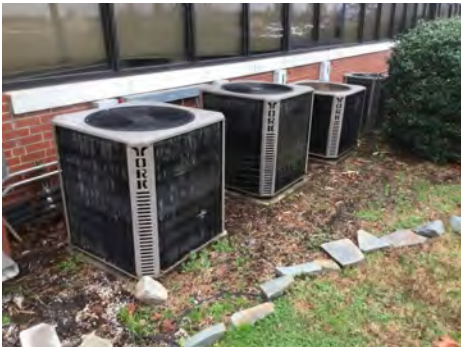
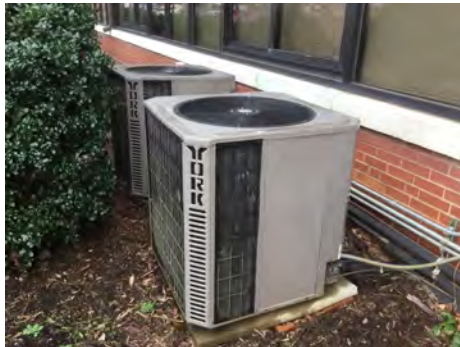
**System:** D3050 - Terminal & Package Units

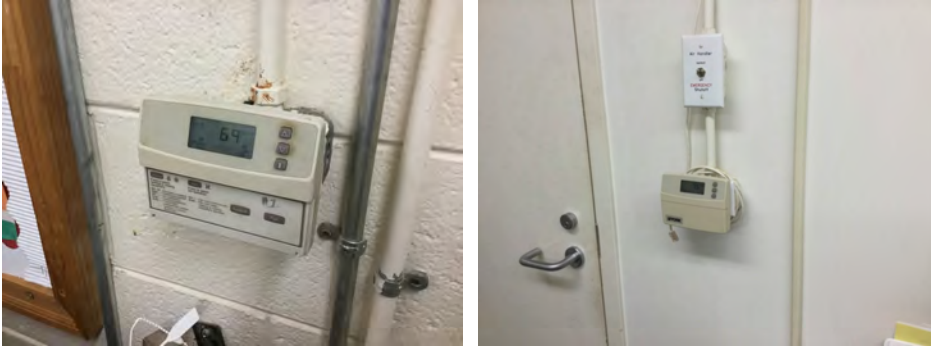
**System:** D3060 - Controls & Instrumentation

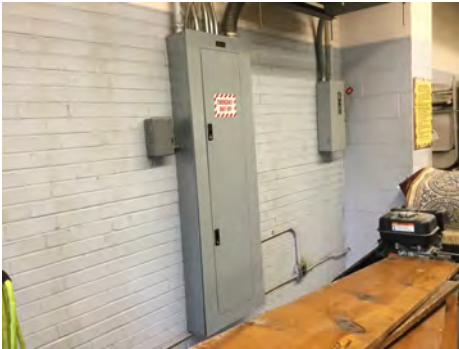
**System:** D5010 - Electrical Service/Distribution

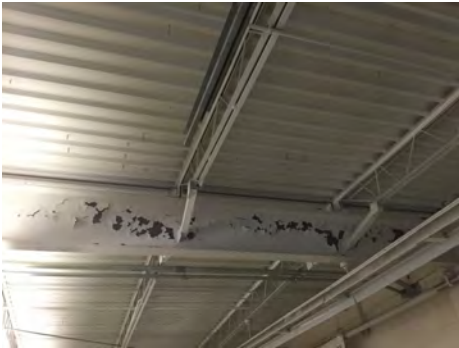
**System:** D5020 - Branch Wiring

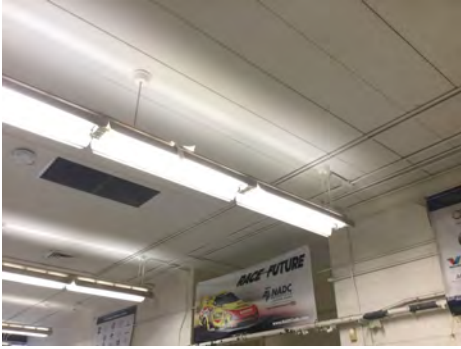
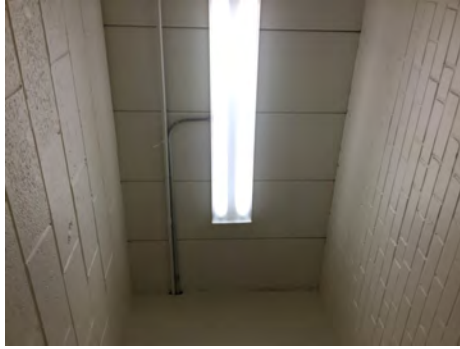
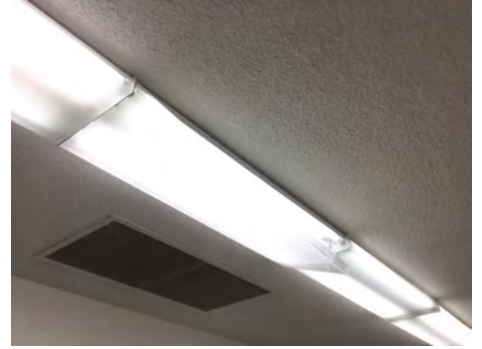
**System:** D5020 - Lighting

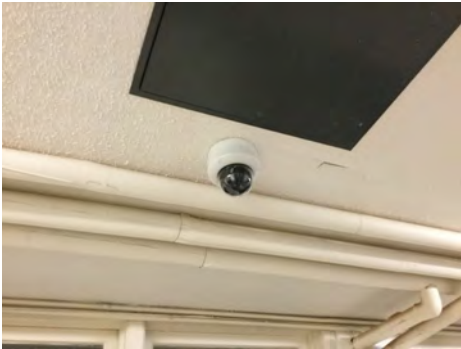
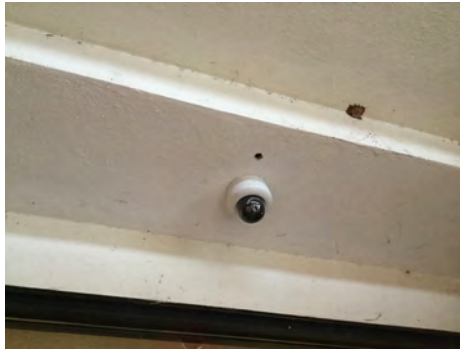
**System:** D5030810 - Security & Detection Systems

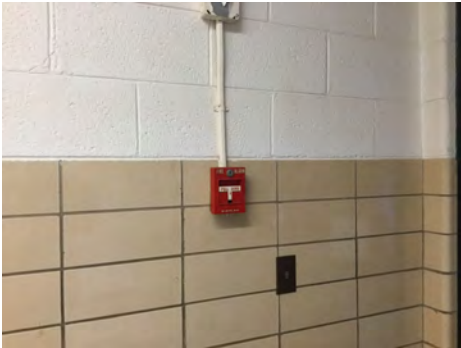
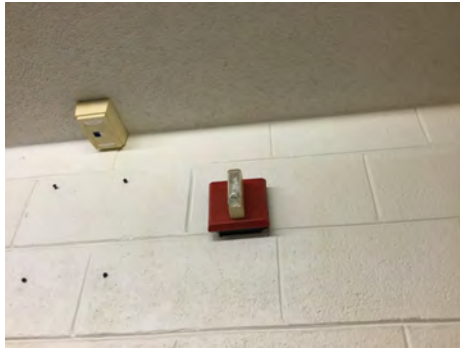
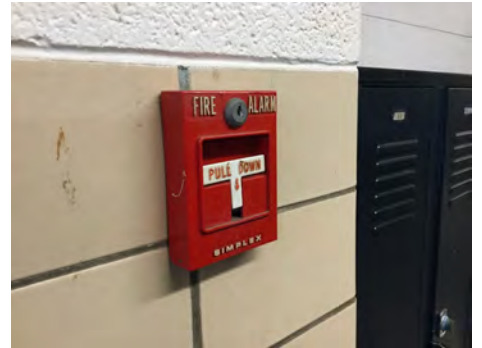
**System:** D5030910 - Fire Alarm Systems

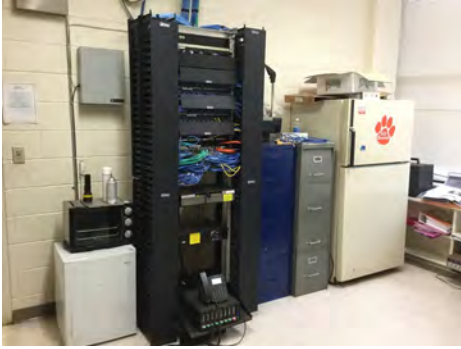
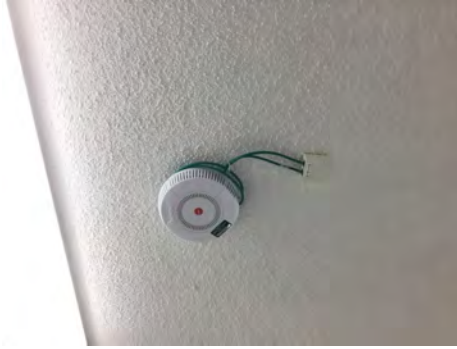
**System:** D5030920 - Data Communication

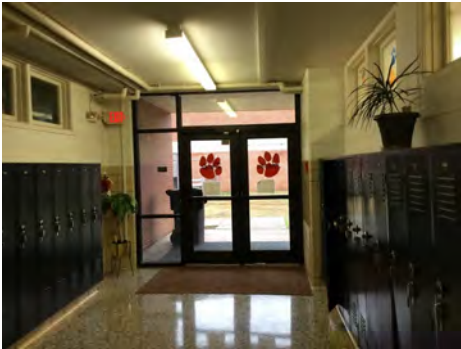
**System:** D5090 - Other Electrical Systems

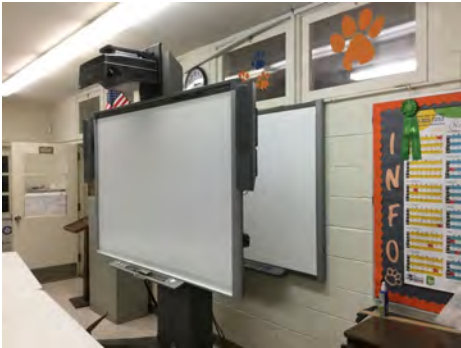
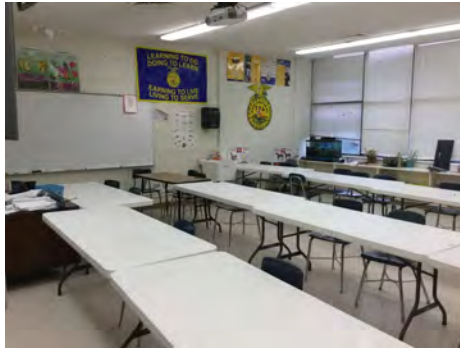
**System:** E1020 - Institutional Equipment

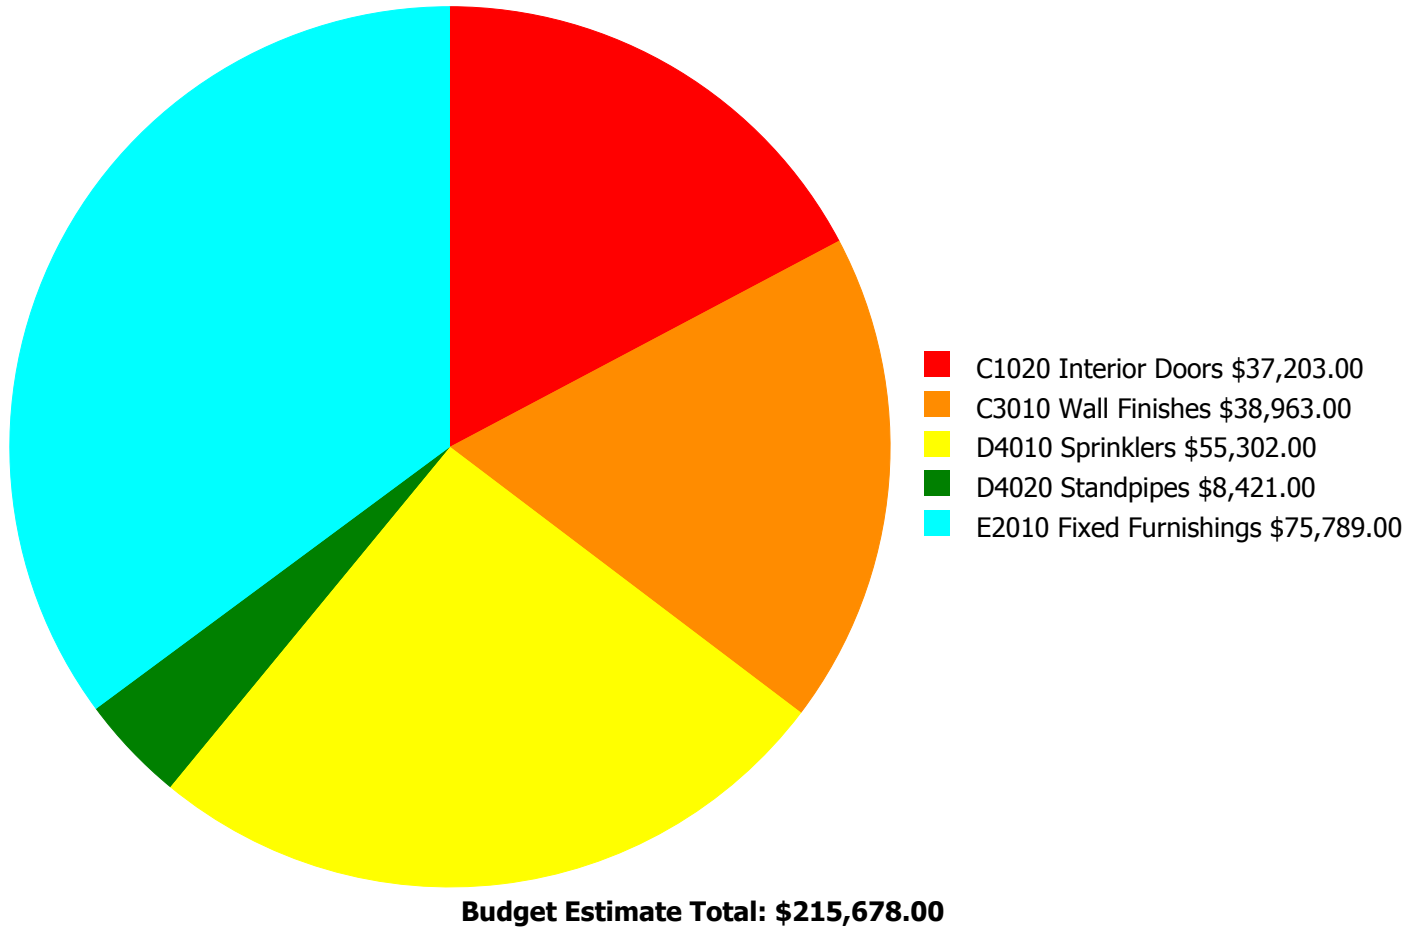
## Deficiency Summary by System

Current deficiencies included assemblies that have reached or exceeded their design life or components of the assemblies that are in need of repair. Assemblies that have reached their design life are identified as current deficiencies and assigned the distress 'Beyond Useful Life'. The following chart lists all current deficiencies associated with this facility.
