# Anson Middle

## Campus Assessment Report

March 7, 2017

## Campus Assessment Report - 1966 Building, Cafe/Gym

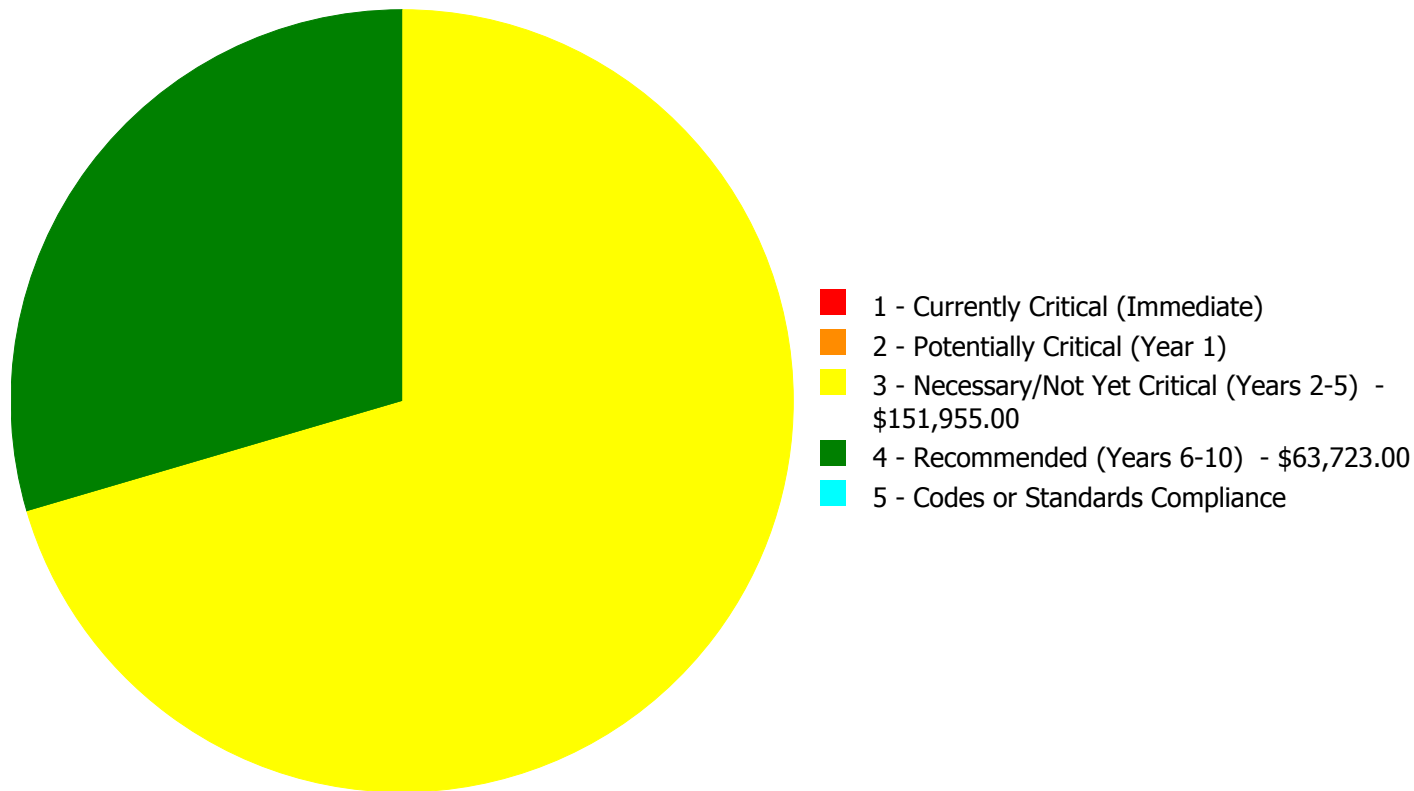
### Deficiency Summary by Priority

The following chart shows the total repair costs broken down by priority. Assessors assigned deficiencies within eCOMET to one of the following priority categories:

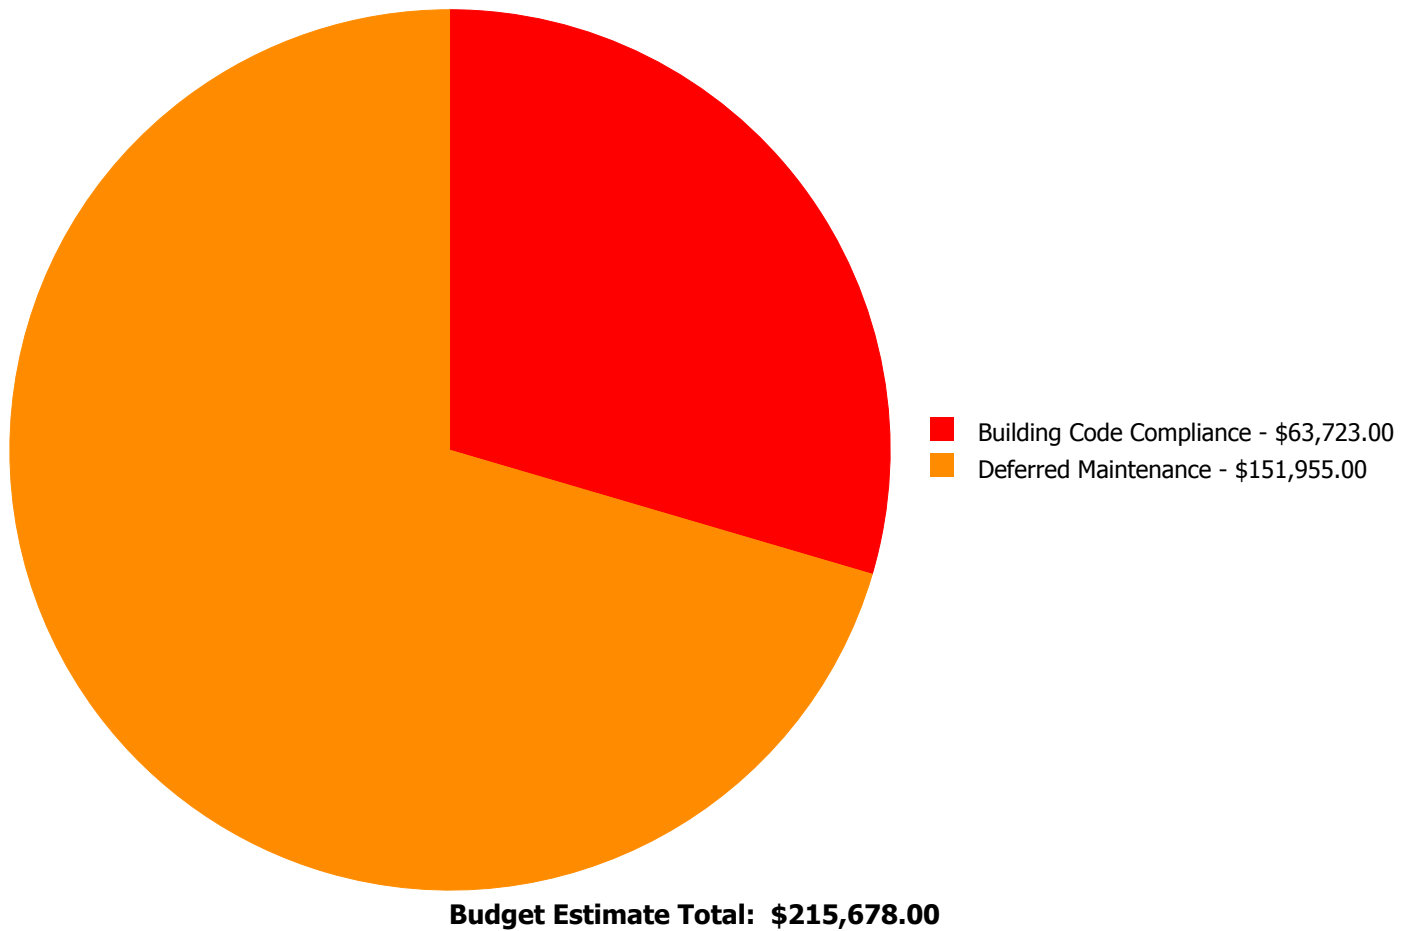
## Deficiency Summary by Category

The following chart shows the total repair costs broken down by deficiency categories. Assessors assigned deficiencies to one of the following categories:

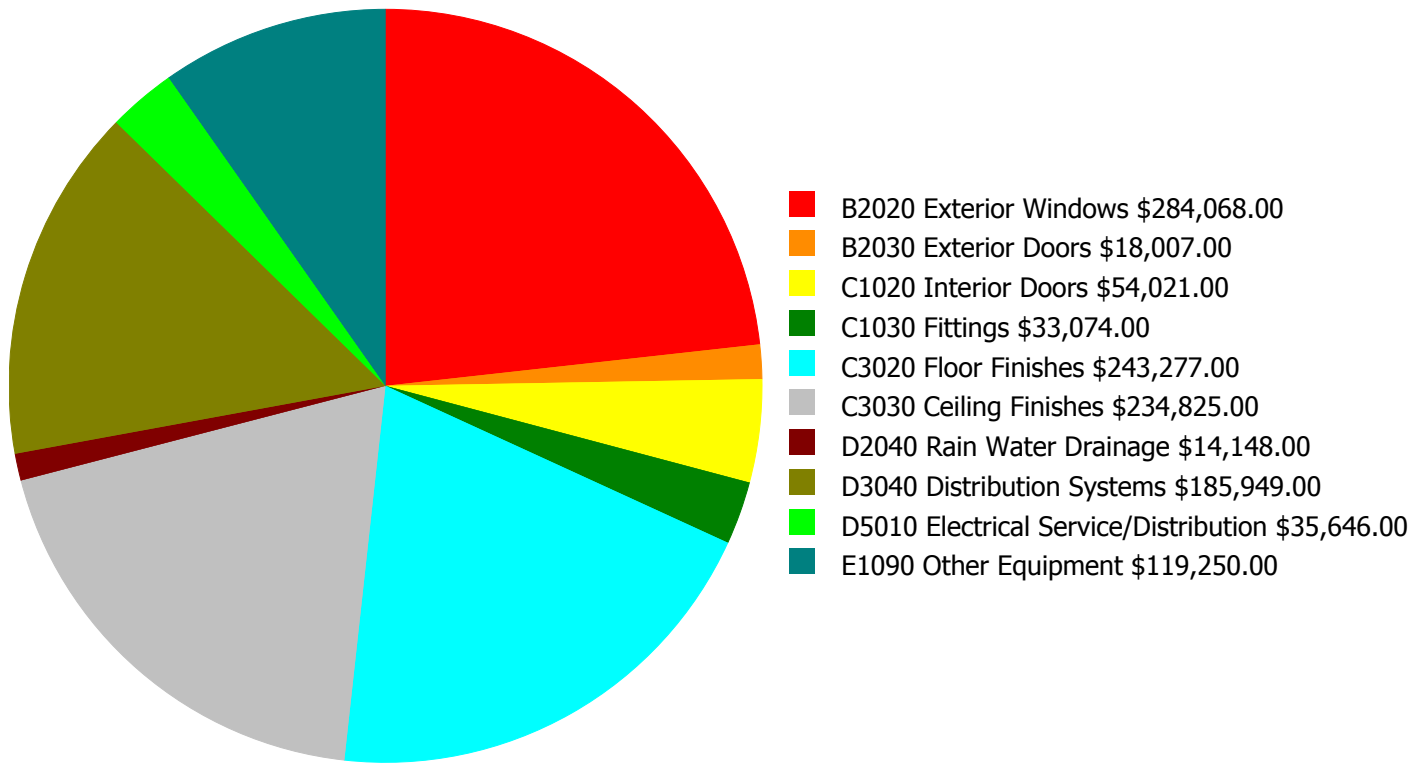
### Deficiency Summary by System

Current deficiencies included assemblies that have reached or exceeded their design life or components of the assemblies that are in need of repair. Assemblies that have reached their design life are identified as current deficiencies and assigned the distress 'Beyond Useful Life'. The following chart lists all current deficiencies associated with this facility.

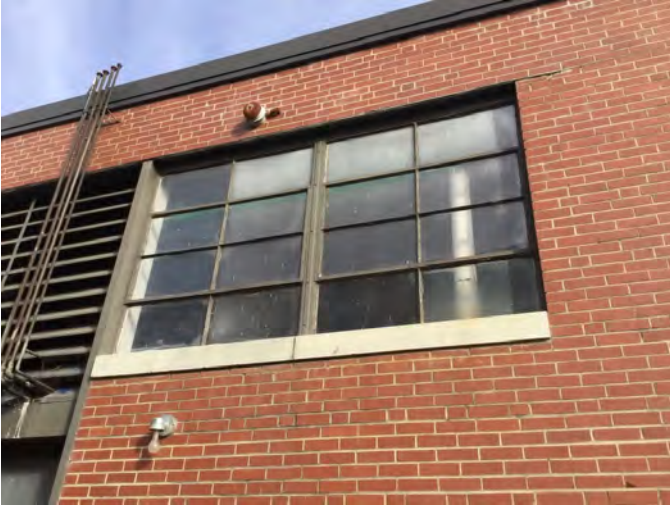
#### System: B2020 - Exterior Windows

**Location:** Exterior Walls  
**Distress:** Beyond Service Life  
**Category:** Deferred Maintenance  
**Priority:** 3 - Necessary/Not Yet Critical (Years 2-5)  
**Correction:** Renew System  
**Qty:** 16,704.00  
**Unit of Measure:** S.F.  
**Estimate:** \$284,068.00  
**Assessor Name:** Eduardo Lopez  
**Date Created:** 01/04/2017

**Notes:** The exterior windows are aged, rusted, not energy efficient and should be replaced.

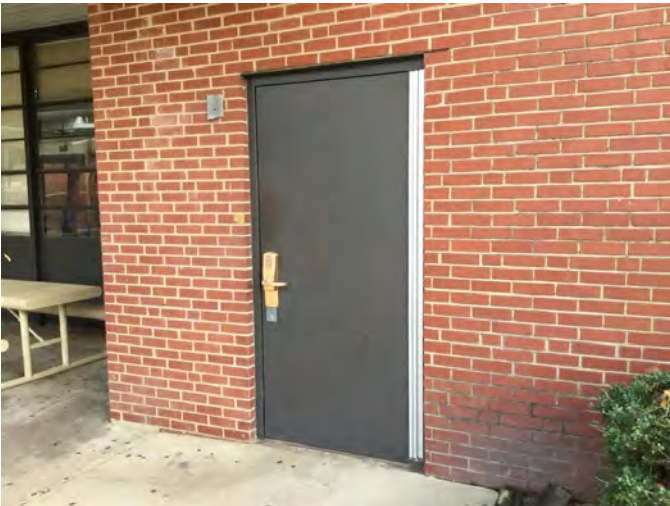
#### System: B2030 - Exterior Doors

**Location:** Exterior Walls  
**Distress:** Beyond Service Life  
**Category:** Deferred Maintenance  
**Priority:** 3 - Necessary/Not Yet Critical (Years 2-5)  
**Correction:** Renew System  
**Qty:** 16,704.00  
**Unit of Measure:** S.F.  
**Estimate:** \$18,007.00  
**Assessor Name:** Eduardo Lopez  
**Date Created:** 01/04/2017

**Notes:** The exterior doors are aged, rusted and should be replaced.

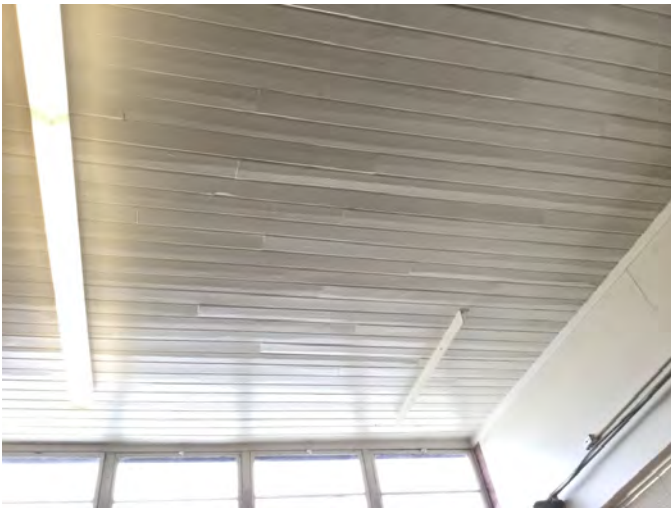
**System: C3030 - Ceiling Finishes**

**Location:** Throughout the Building  
**Distress:** Beyond Service Life  
**Category:** Deferred Maintenance  
**Priority:** 3 - Necessary/Not Yet Critical (Years 2-5)  
**Correction:** Renew System  
**Qty:** 16,704.00  
**Unit of Measure:** S.F.  
**Estimate:** \$234,825.00  
**Assessor Name:** Eduardo Lopez  
**Date Created:** 01/04/2017

**Notes:** The original ceiling finishes are aged, failing and should be replaced.

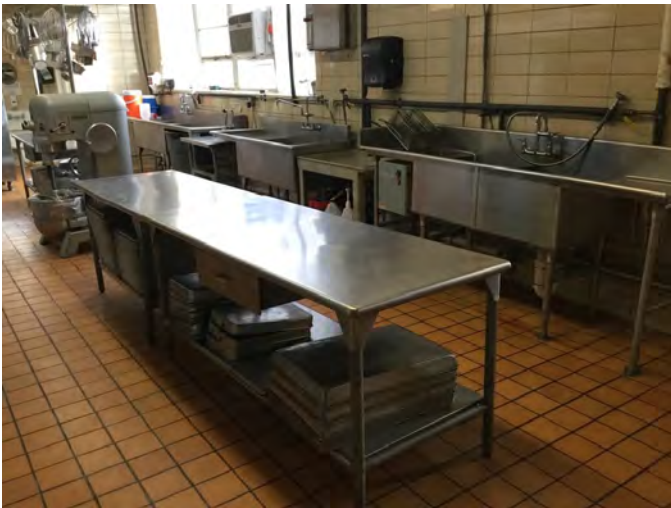
**System: E1090 - Other Equipment**

**Location:** Throughout the Building  
**Distress:** Beyond Service Life  
**Category:** Deferred Maintenance  
**Priority:** 3 - Necessary/Not Yet Critical (Years 2-5)  
**Correction:** Renew System  
**Qty:** 16,704.00  
**Unit of Measure:** S.F.  
**Estimate:** \$119,250.00  
**Assessor Name:** Eduardo Lopez  
**Date Created:** 01/04/2017

**Notes:** The other equipment is in deteriorating conditions and should be replaced.

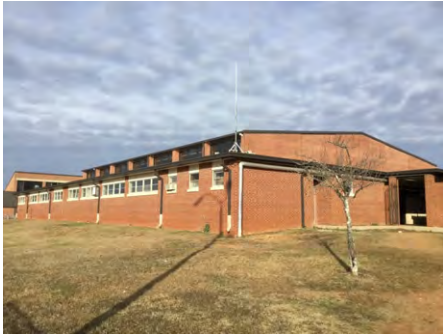
1). Southeast Elevation - Feb 16, 2017

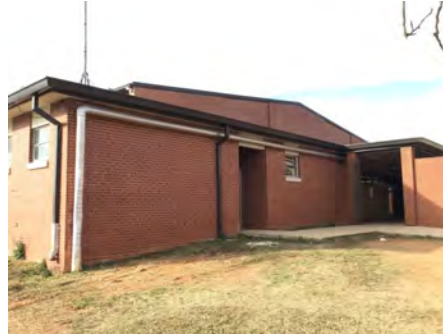
2). East Elevation - Feb 16, 2017

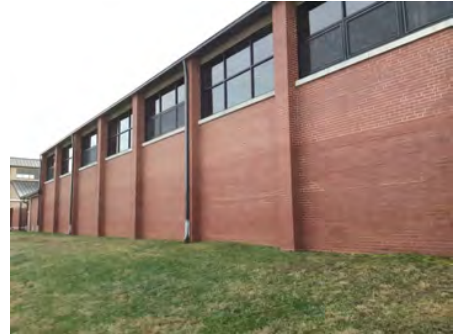
3). South Elevation - Feb 16, 2017

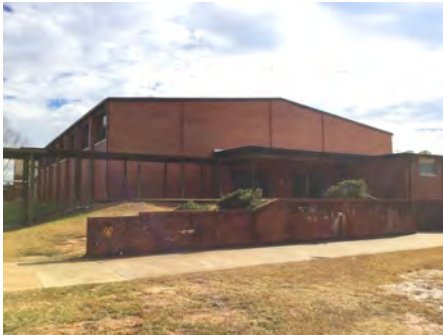
4). West Elevation - Feb 16, 2017

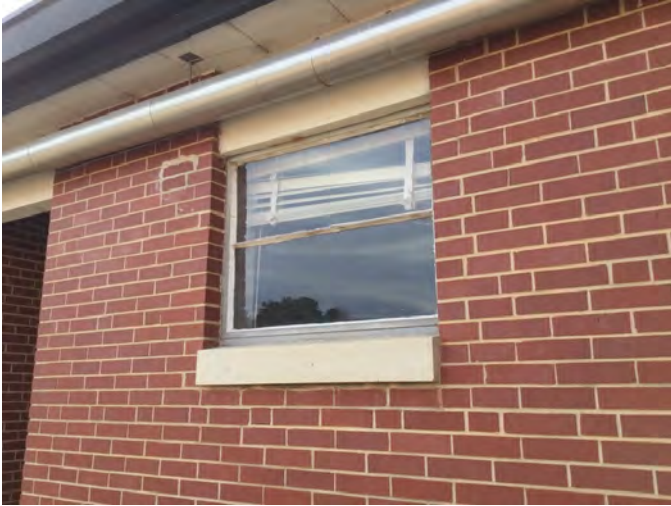
#### System: B2020 - Exterior Windows

**Location:** Exterior Walls  
**Distress:** Beyond Service Life  
**Category:** Deferred Maintenance  
**Priority:** 3 - Necessary/Not Yet Critical (Years 2-5)  
**Correction:** Renew System  
**Qty:** 21,722.00  
**Unit of Measure:** S.F.  
**Estimate:** \$193,065.00  
**Assessor Name:** Eduardo Lopez  
**Date Created:** 02/16/2017

**Notes:** The exterior windows are aged, rusted, not energy efficient and should be replaced.

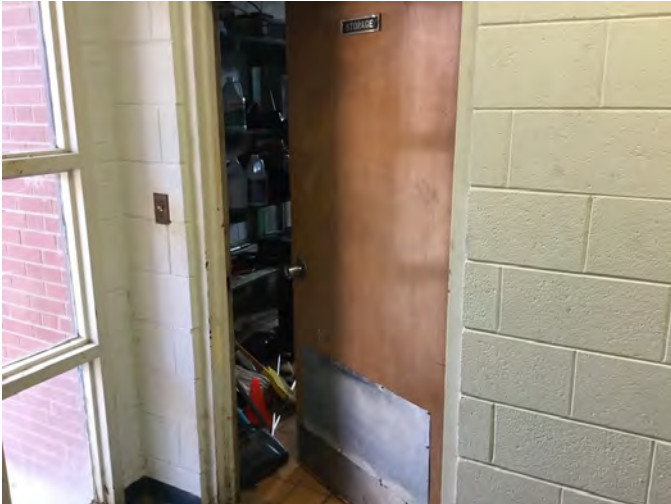
#### System: C1020 - Interior Doors

**Location:** Throughout the Building  
**Distress:** Beyond Service Life  
**Category:** Deferred Maintenance  
**Priority:** 3 - Necessary/Not Yet Critical (Years 2-5)  
**Correction:** Renew System  
**Qty:** 21,722.00  
**Unit of Measure:** S.F.  
**Estimate:** \$89,364.00  
**Assessor Name:** Eduardo Lopez  
**Date Created:** 02/16/2017

**Notes:** The interior doors are aged, failing, most hardware is not ADA or code compliant and should be replaced.

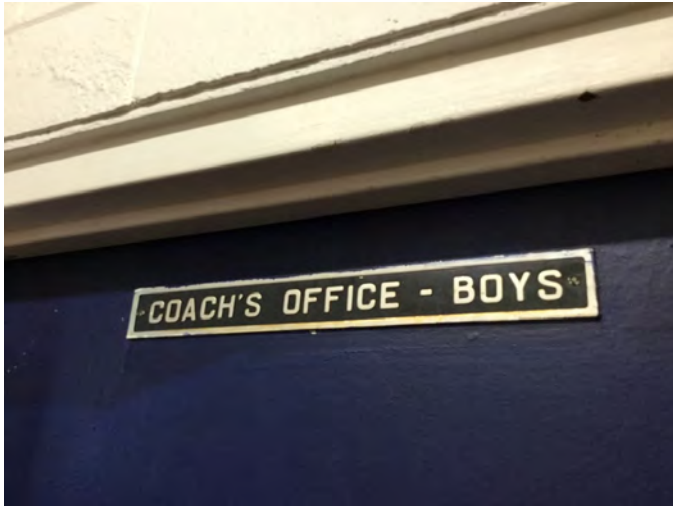
**System: C1030 - Fittings**

**Location:** Throughout the Building  
**Distress:** Beyond Service Life  
**Category:** Deferred Maintenance  
**Priority:** 3 - Necessary/Not Yet Critical (Years 2-5)  
**Correction:** Renew System  
**Qty:** 21,722.00  
**Unit of Measure:** S.F.  
**Estimate:** \$43,010.00  
**Assessor Name:** Eduardo Lopez  
**Date Created:** 02/16/2017

**Notes:** The fittings throughout the building are aged, in marginal condition, handrails and room signage are not ADA compliant and should be replaced.

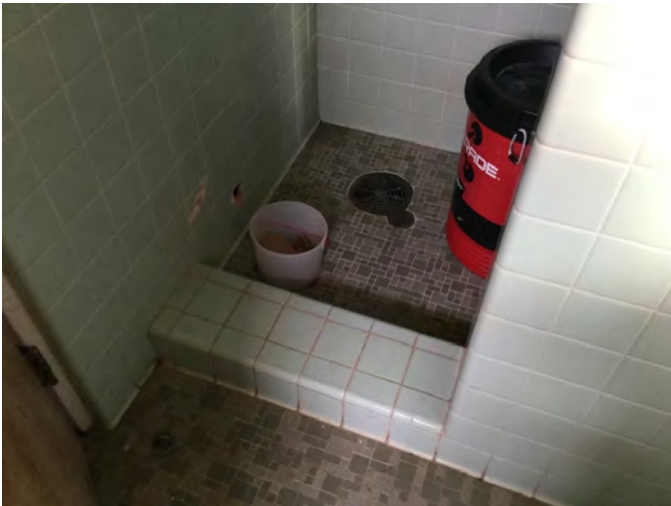
**System: D2030 - Sanitary Waste**

**Location:** Throughout the Building  
**Distress:** Beyond Service Life  
**Category:** Deferred Maintenance  
**Priority:** 3 - Necessary/Not Yet Critical (Years 2-5)  
**Correction:** Renew System  
**Qty:** 21,722.00  
**Unit of Measure:** S.F.  
**Estimate:** \$74,789.00  
**Assessor Name:** Eduardo Lopez  
**Date Created:** 02/16/2017

**Notes:** The sanitary waste system is beyond its expected service life and should be replaced.

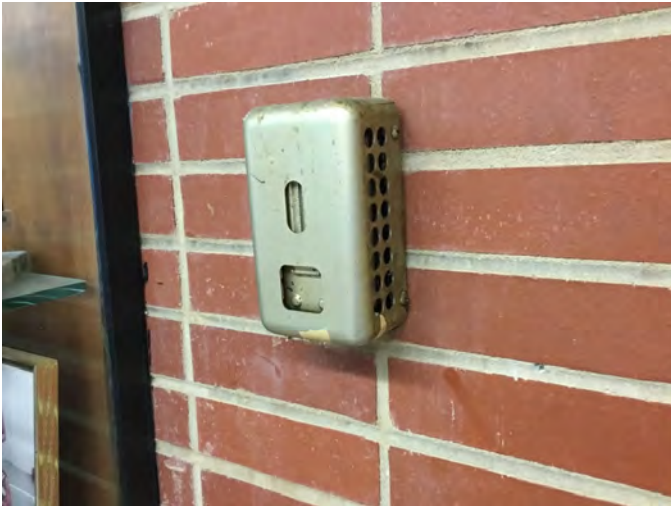
**System: D3060 - Controls & Instrumentation**

**Location:** Throughout the Building  
**Distress:** Beyond Service Life  
**Category:** Deferred Maintenance  
**Priority:** 3 - Necessary/Not Yet Critical (Years 2-5)  
**Correction:** Renew System  
**Qty:** 21,722.00  
**Unit of Measure:** S.F.  
**Estimate:** \$76,700.00  
**Assessor Name:** Eduardo Lopez  
**Date Created:** 02/16/2017

**Notes:** The controls and instrumentation system is in marginal condition and should be schedule for replacement.

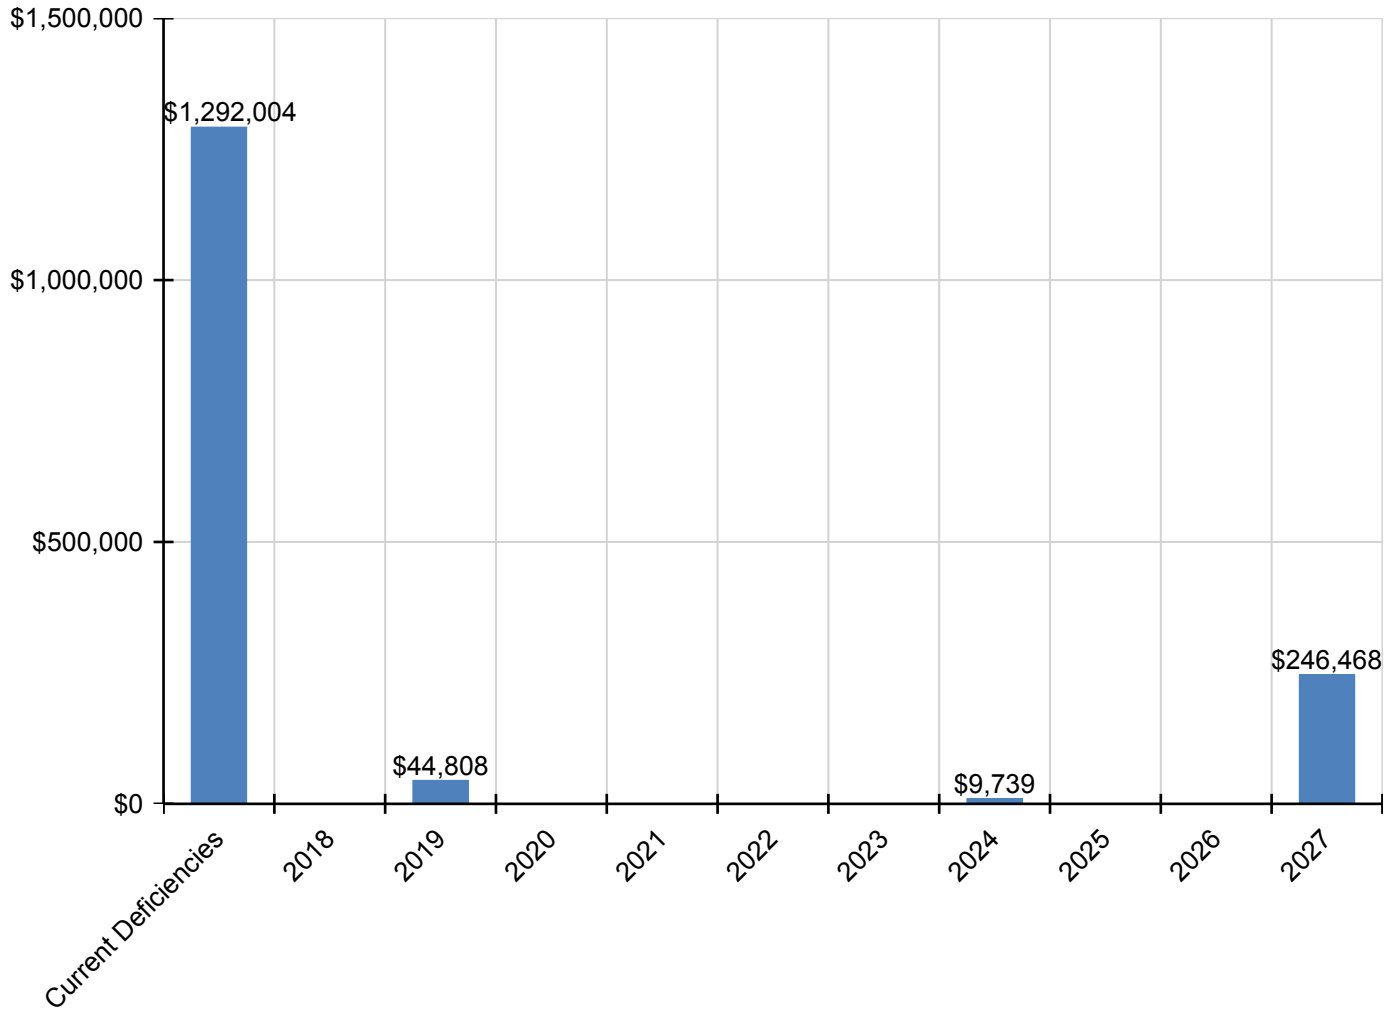
## Forecasted Capital Renewal Requirement

The following chart shows the current building deficiencies and forecasting capital renewal or sustainment requirements over the next ten years.

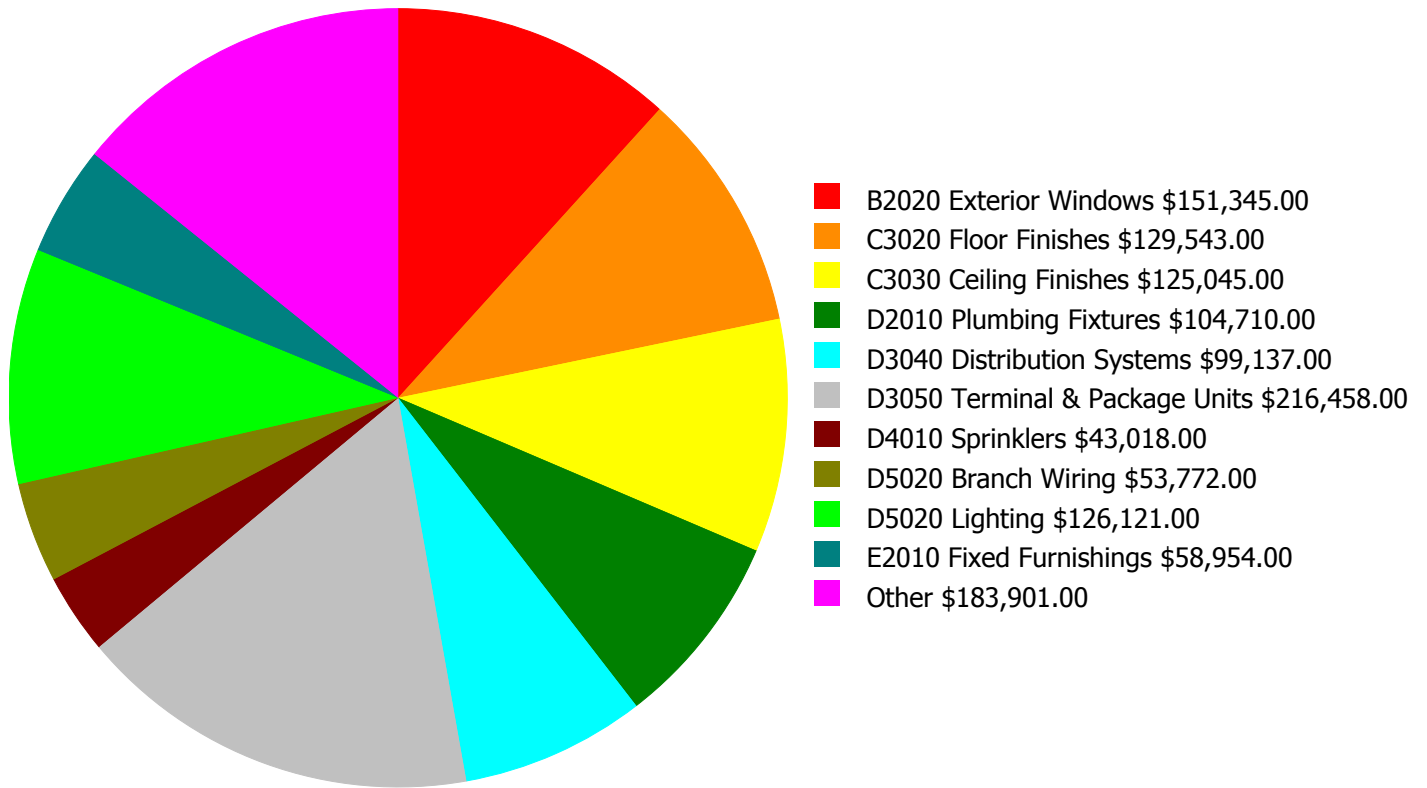
### Deficiency Summary by System

Current deficiencies included assemblies that have reached or exceeded their design life or components of the assemblies that are in need of repair. Assemblies that have reached their design life are identified as current deficiencies and assigned the distress 'Beyond Useful Life'. The following chart lists all current deficiencies associated with this facility.

**Budget Estimate Total: \$1,292,004.00**

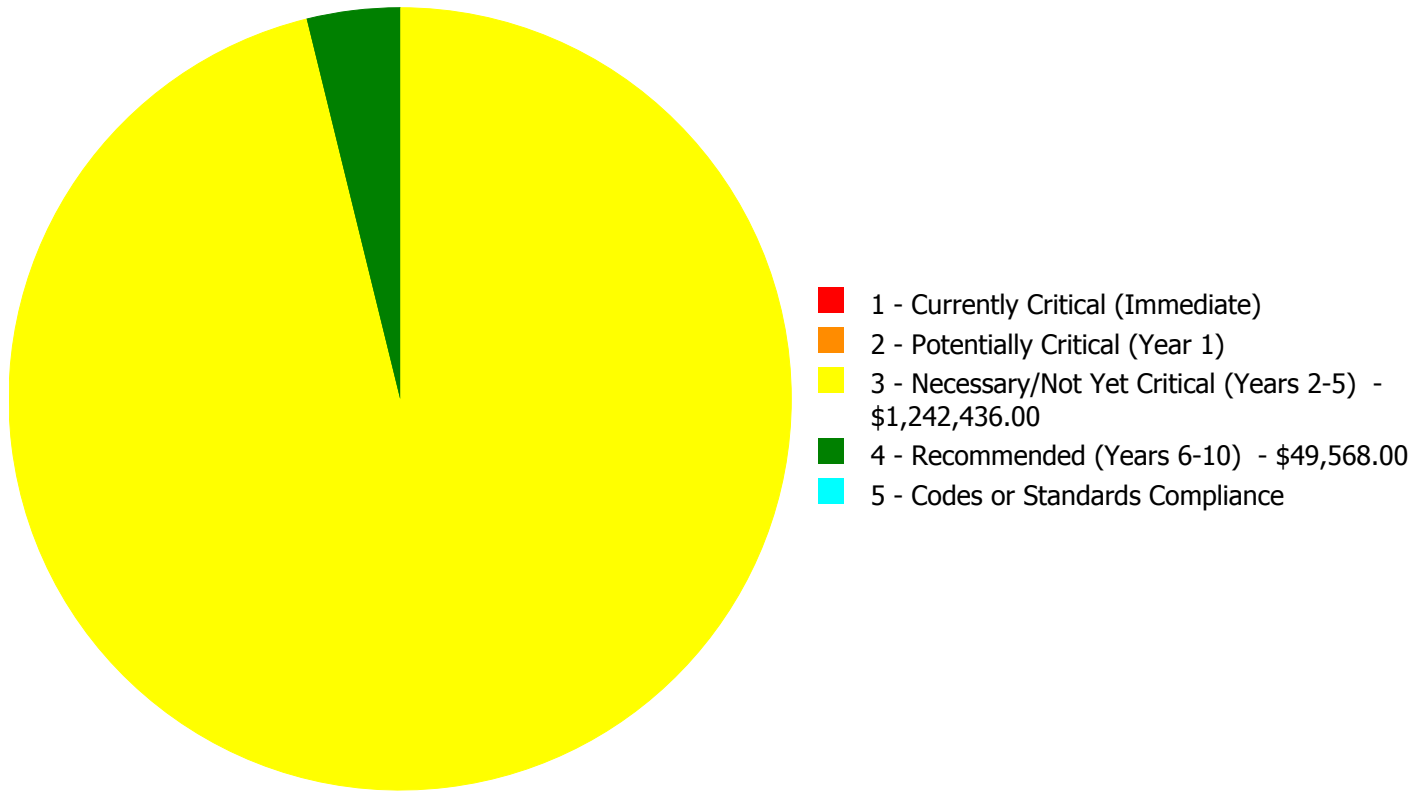
## Deficiency Summary by Priority

The following chart shows the total repair costs broken down by priority. Assessors assigned deficiencies within eCOMET to one of the following priority categories:

**Budget Estimate Total: \$1,292,004.00**

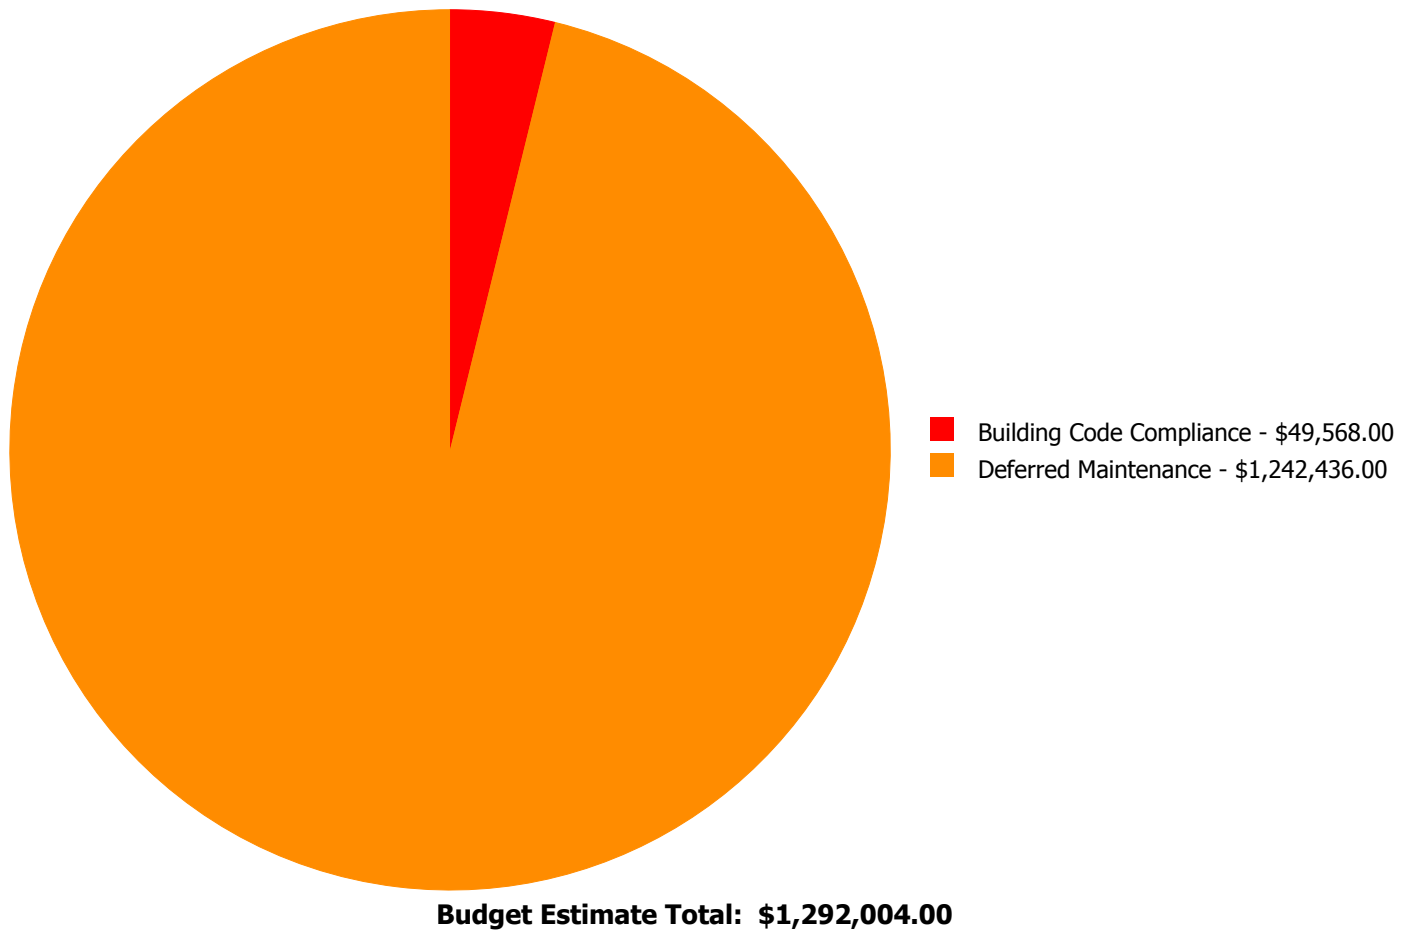
## Deficiency Summary by Category

The following chart shows the total repair costs broken down by deficiency categories. Assessors assigned deficiencies to one of the following categories:

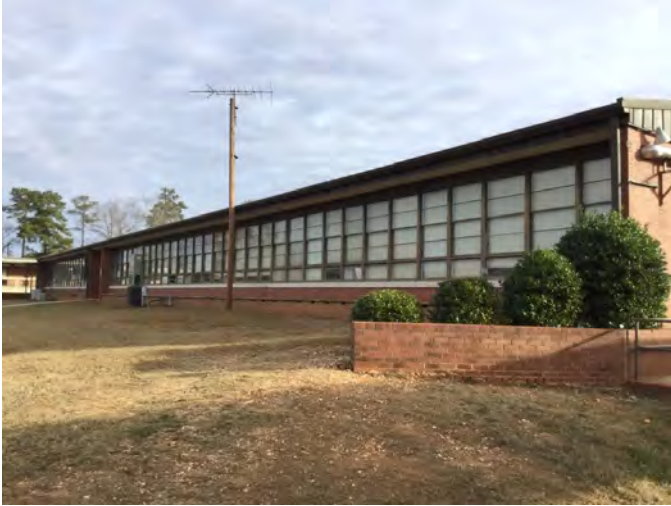
#### System: B2020 - Exterior Windows

**Location:** Exterior Walls  
**Distress:** Beyond Service Life  
**Category:** Deferred Maintenance  
**Priority:** 3 - Necessary/Not Yet Critical (Years 2-5)  
**Correction:** Renew System  
**Qty:** 8,888.00  
**Unit of Measure:** S.F.  
**Estimate:** \$151,345.00  
**Assessor Name:** Eduardo Lopez  
**Date Created:** 01/04/2017

**Notes:** The exterior windows are aged, rusted, not energy efficient and should be replaced.

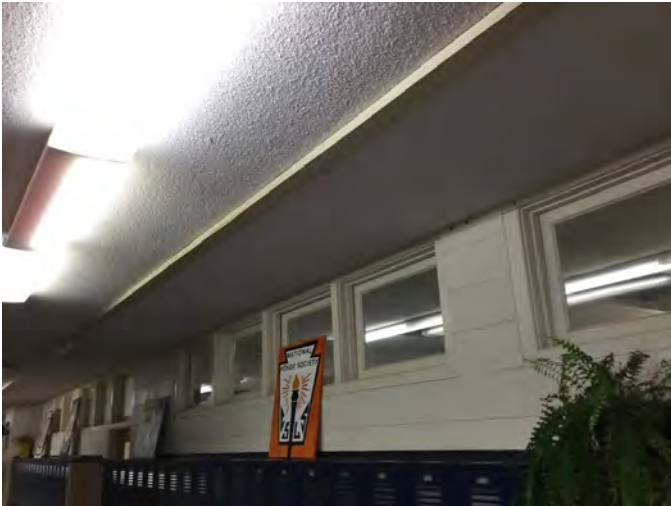
**System: C3030 - Ceiling Finishes**

**Location:** Throughout the Building  
**Distress:** Beyond Service Life  
**Category:** Deferred Maintenance  
**Priority:** 3 - Necessary/Not Yet Critical (Years 2-5)  
**Correction:** Renew System  
**Qty:** 8,888.00  
**Unit of Measure:** S.F.  
**Estimate:** \$125,045.00  
**Assessor Name:** Eduardo Lopez  
**Date Created:** 01/04/2017

**Notes:** The original ceiling finishes are aged, failing and should be replaced.

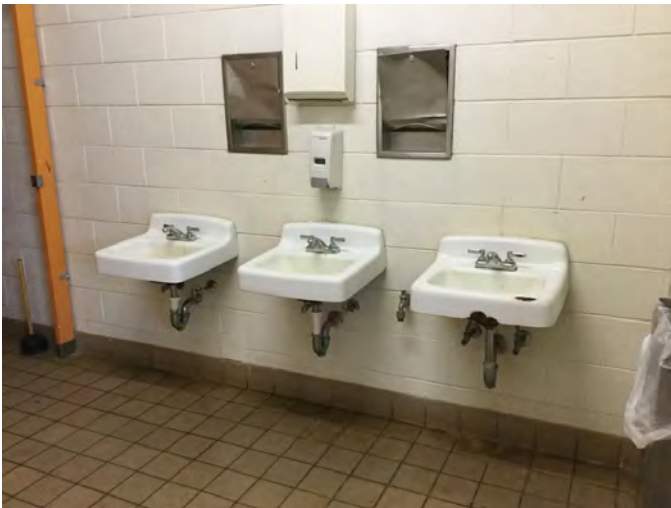
**System: D2010 - Plumbing Fixtures**

**Location:** Throughout the Building  
**Distress:** Beyond Service Life  
**Category:** Deferred Maintenance  
**Priority:** 3 - Necessary/Not Yet Critical (Years 2-5)  
**Correction:** Renew System  
**Qty:** 7,537.00  
**Unit of Measure:** S.F.  
**Estimate:** \$119,801.00  
**Assessor Name:** Eduardo Lopez  
**Date Created:** 02/16/2017

**Notes:** Plumbing fixtures are in operational conditions. However, they are aged, not ADA compliant, and should be scheduled for replacement.

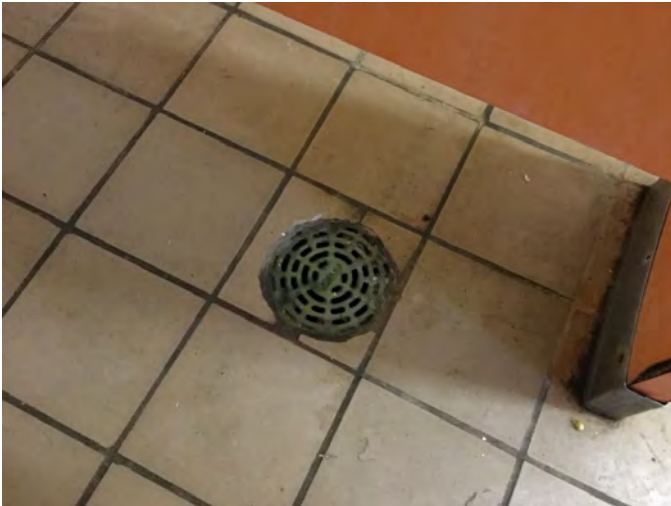
**System: D2030 - Sanitary Waste**

**Location:** Throughout the Building  
**Distress:** Beyond Service Life  
**Category:** Deferred Maintenance  
**Priority:** 3 - Necessary/Not Yet Critical (Years 2-5)  
**Correction:** Renew System  
**Qty:** 7,537.00  
**Unit of Measure:** S.F.  
**Estimate:** \$25,950.00  
**Assessor Name:** Eduardo Lopez  
**Date Created:** 02/16/2017

**Notes:** The sanitary waste system is beyond its expected service life and should be replaced.

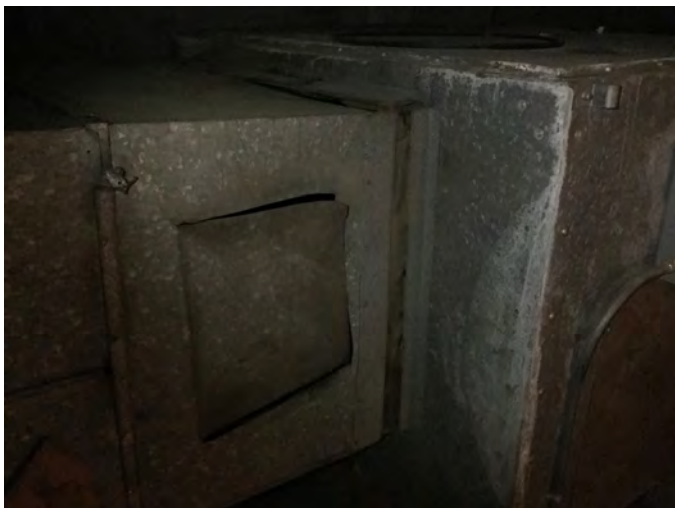
**System: D3040 - Distribution Systems**

**Location:** Throughout the Building  
**Distress:** Beyond Service Life  
**Category:** Deferred Maintenance  
**Priority:** 3 - Necessary/Not Yet Critical (Years 2-5)  
**Correction:** Renew System  
**Qty:** 7,537.00  
**Unit of Measure:** S.F.  
**Estimate:** \$183,307.00  
**Assessor Name:** Eduardo Lopez  
**Date Created:** 02/16/2017

**Notes:** Distribution systems are aged, becoming logistically unsupportable, and should be replaced.

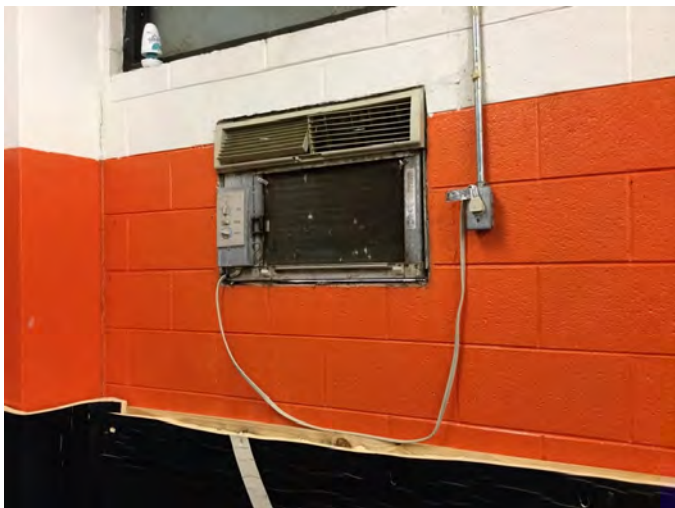
**System: D3050 - Terminal & Package Units**

**Location:** Throughout the Building  
**Distress:** Beyond Service Life  
**Category:** Deferred Maintenance  
**Priority:** 3 - Necessary/Not Yet Critical (Years 2-5)  
**Correction:** Renew System  
**Qty:** 7,537.00  
**Unit of Measure:** S.F.  
**Estimate:** \$17,742.00  
**Assessor Name:** Eduardo Lopez  
**Date Created:** 02/16/2017

**Notes:** Terminal and package units are beyond their expected service life and should be scheduled for replacement.

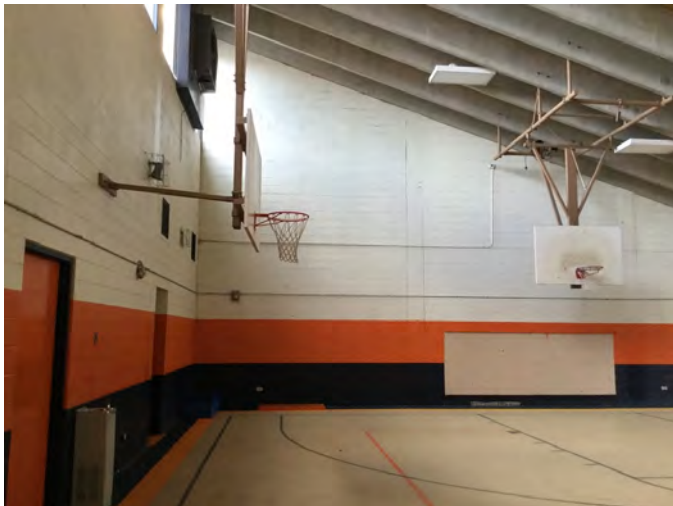
**System: E1090 - Other Equipment**

**Location:** Throughout the Building  
**Distress:** Beyond Service Life  
**Category:** Deferred Maintenance  
**Priority:** 3 - Necessary/Not Yet Critical (Years 2-5)  
**Correction:** Renew System  
**Qty:** 7,537.00  
**Unit of Measure:** S.F.  
**Estimate:** \$92,110.00  
**Assessor Name:** Eduardo Lopez  
**Date Created:** 02/16/2017

**Notes:** The other equipment is in deteriorating conditions and should be replaced.

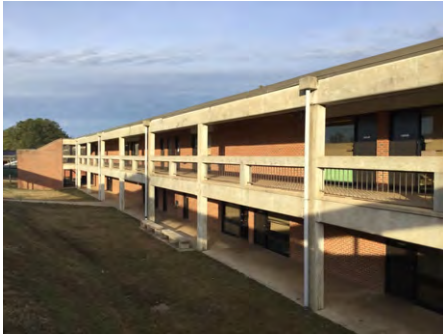
1). South Elevation - Feb 12, 2017

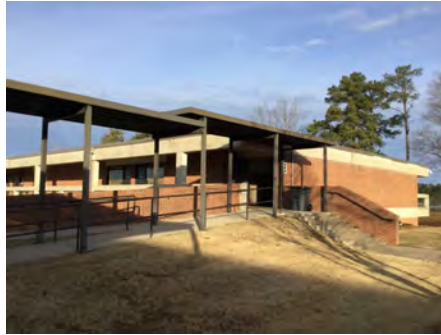
2). East Elevation - Feb 12, 2017

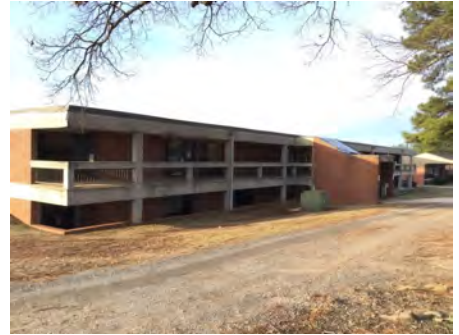
3). North Elevation - Feb 12, 2017

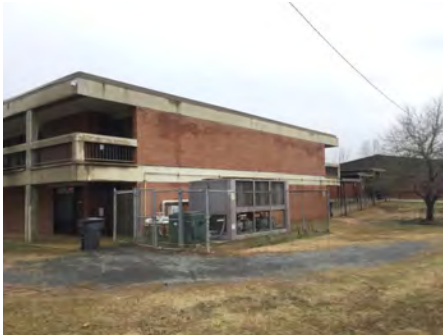
4). West Elevation - Feb 12, 2017

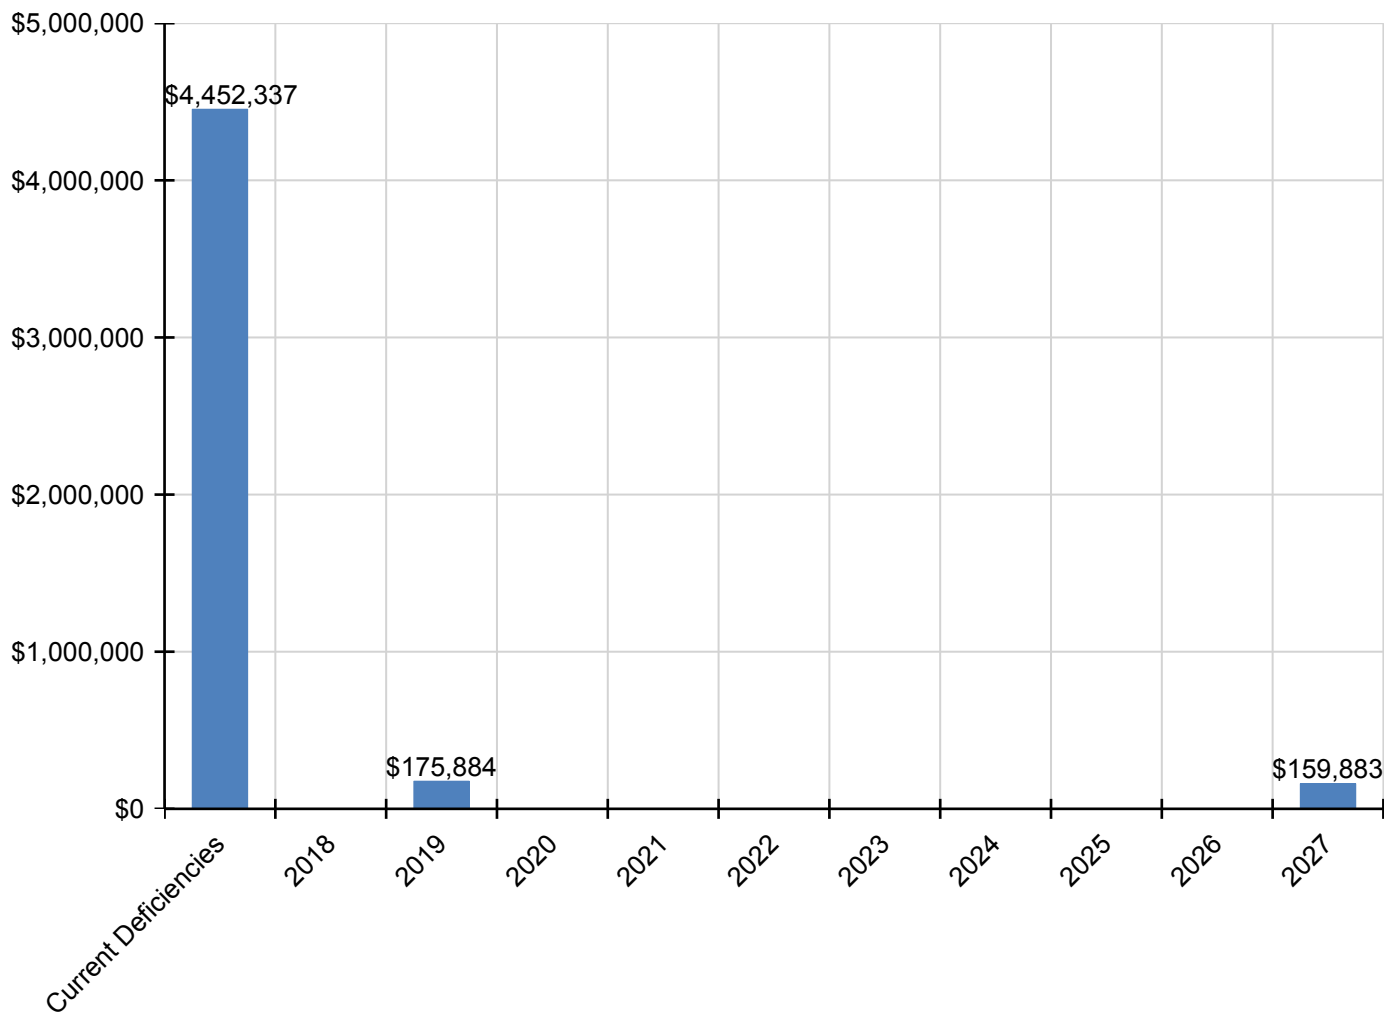
## Forecasted Capital Renewal Requirement

The following chart shows the current building deficiencies and forecasting capital renewal or sustainment requirements over the next ten years.

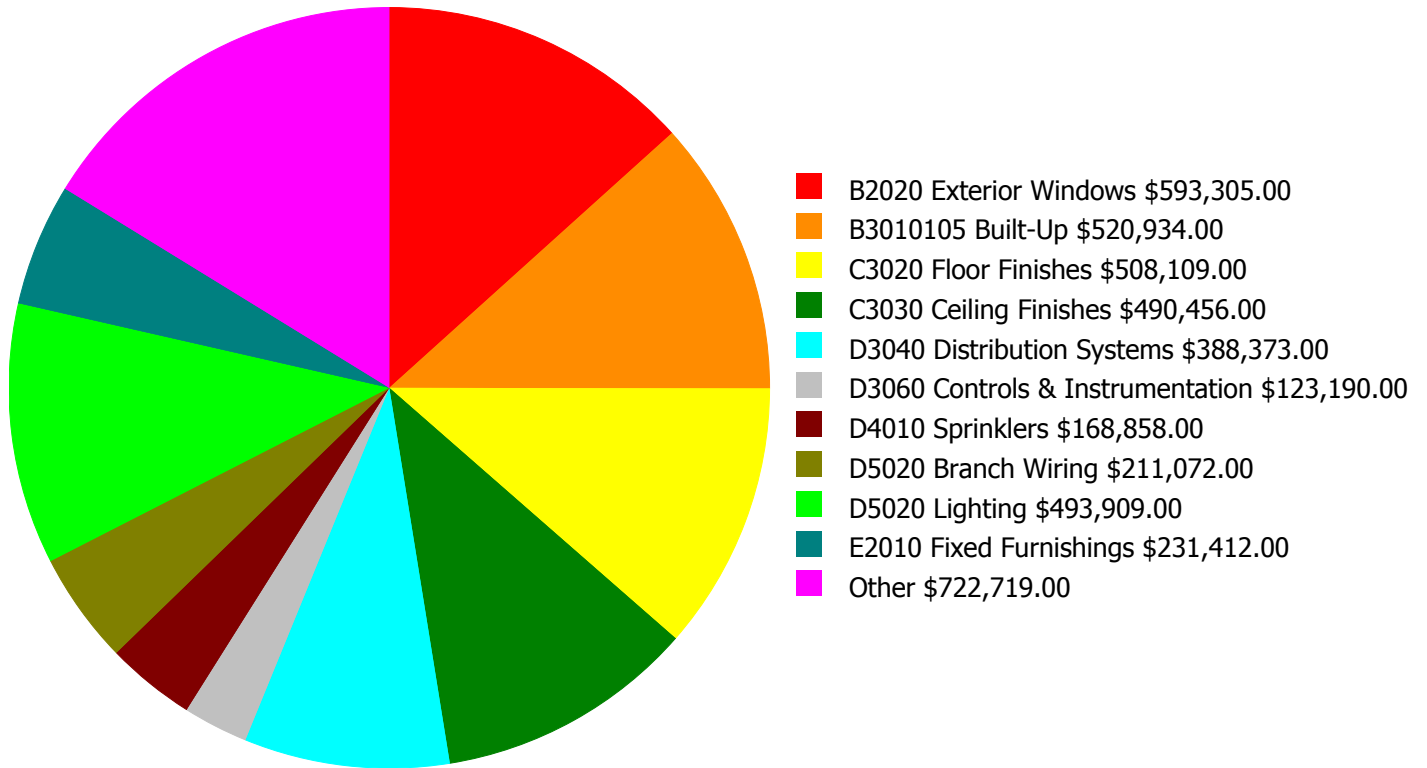
## Deficiency Summary by System

Current deficiencies included assemblies that have reached or exceeded their design life or components of the assemblies that are in need of repair. Assemblies that have reached their design life are identified as current deficiencies and assigned the distress 'Beyond Useful Life'. The following chart lists all current deficiencies associated with this facility.

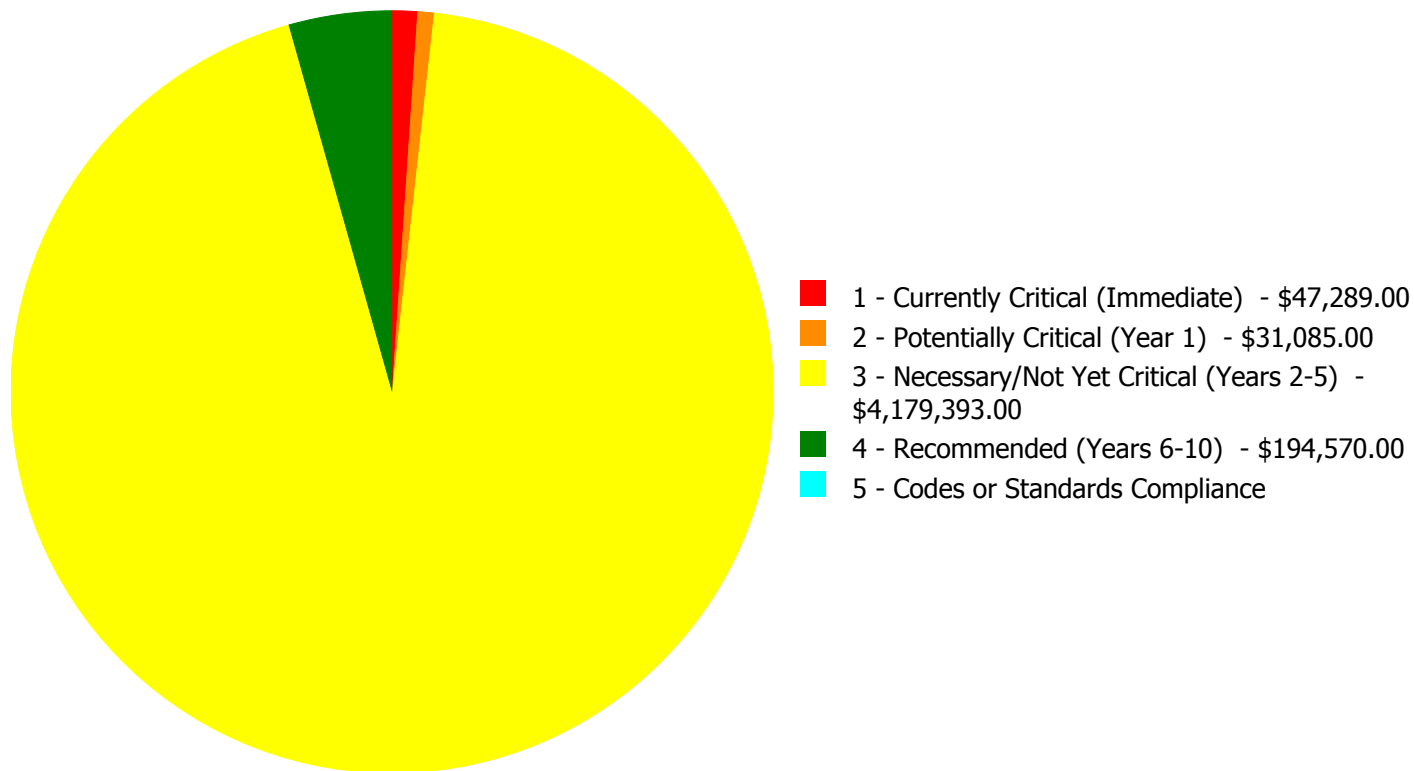
### Deficiency Summary by Priority

The following chart shows the total repair costs broken down by priority. Assessors assigned deficiencies within eCOMET to one of the following priority categories:

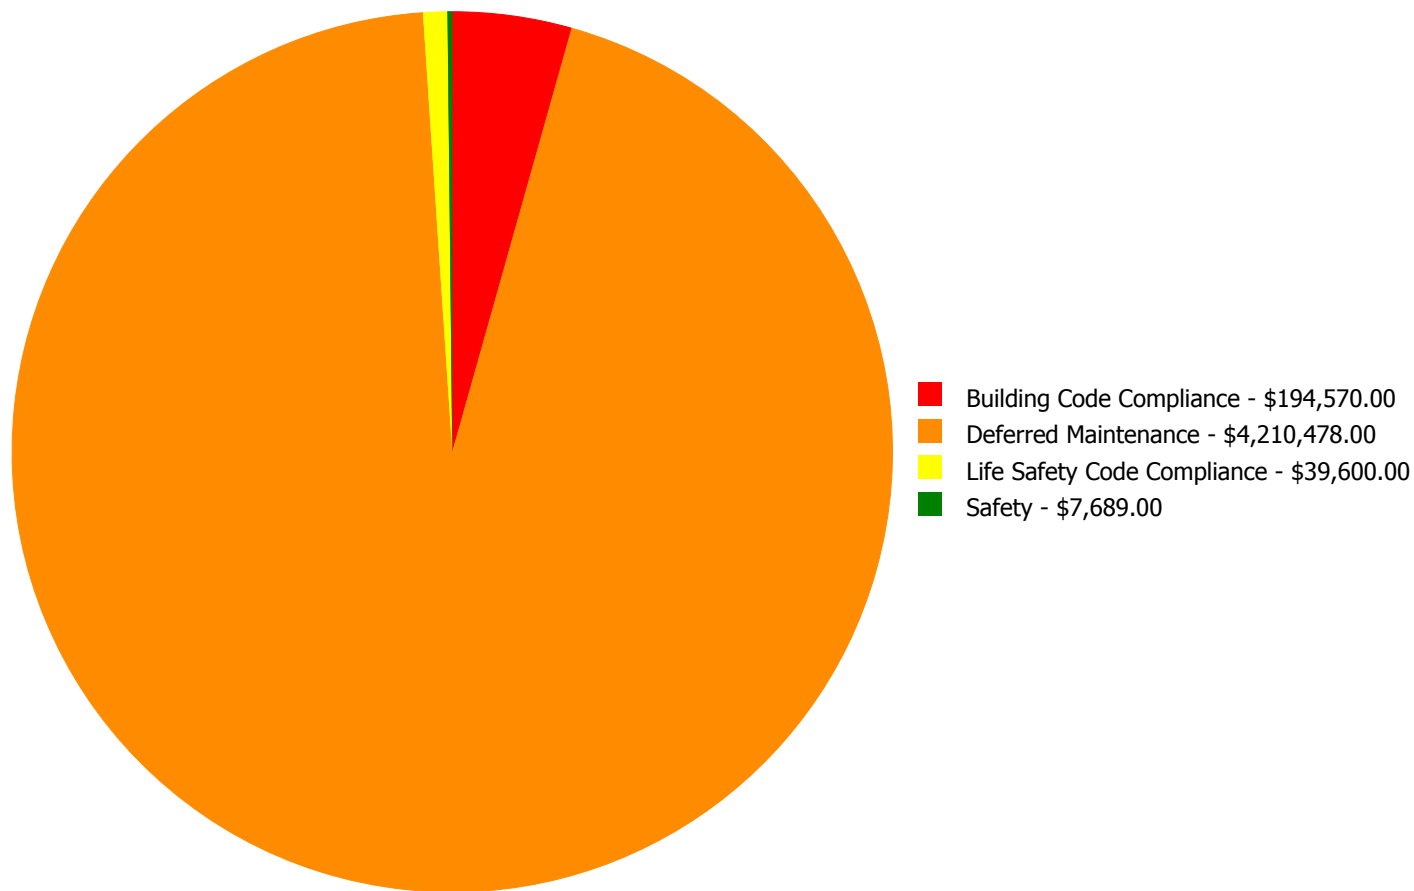
### Deficiency Summary by Category

The following chart shows the total repair costs broken down by deficiency categories. Assessors assigned deficiencies to one of the following categories:
