# Anson Middle

## Campus Assessment Report

March 7, 2017

## Campus Assessment Report - 1966 Building, Cafe/Gym

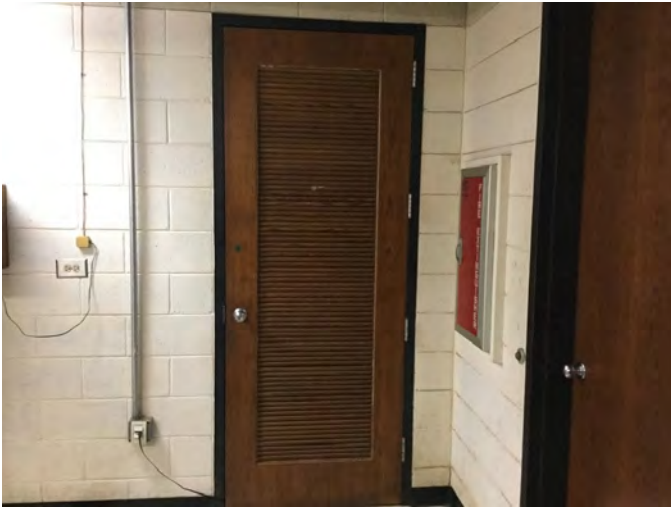
**System: C1020 - Interior Doors**

**Location:** Throughout the Building  
**Distress:** Beyond Service Life  
**Category:** Deferred Maintenance  
**Priority:** 3 - Necessary/Not Yet Critical (Years 2-5)  
**Correction:** Renew System  
**Qty:** 34,888.00  
**Unit of Measure:** S.F.  
**Estimate:** \$112,828.00  
**Assessor Name:** Eduardo Lopez  
**Date Created:** 01/04/2017

**Notes:** The interior doors are aged, failing, most hardware is not ADA or code compliant and should be replaced.

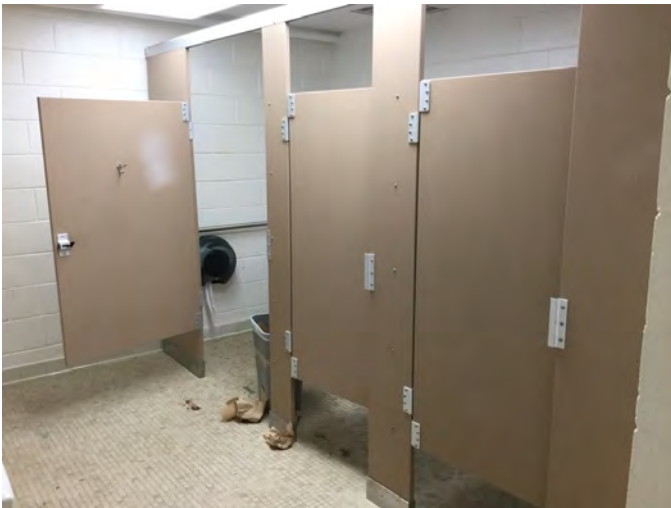
**System: C1030 - Fittings**

**Location:** Throughout the Building  
**Distress:** Beyond Service Life  
**Category:** Deferred Maintenance  
**Priority:** 3 - Necessary/Not Yet Critical (Years 2-5)  
**Correction:** Renew System  
**Qty:** 34,888.00  
**Unit of Measure:** S.F.  
**Estimate:** \$69,078.00  
**Assessor Name:** Eduardo Lopez  
**Date Created:** 01/04/2017

**Notes:** The fittings throughout the building are aged, in marginal condition, handrails and room signage are not ADA compliant and should be replaced.

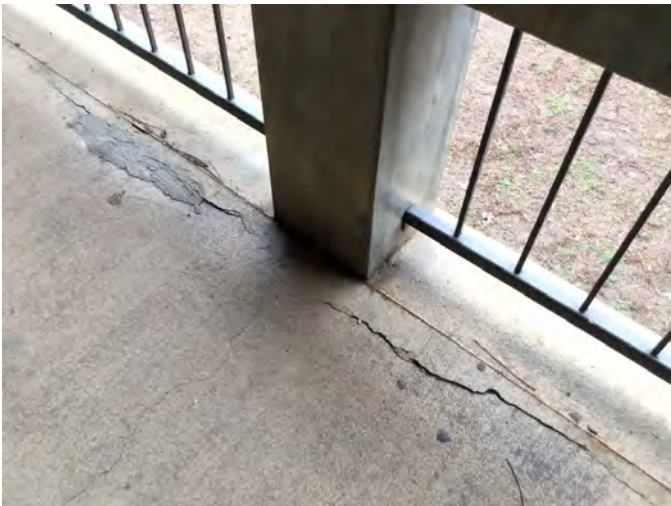
**System: C3020 - Floor Finishes**

**Location:** Throughout the Building  
**Distress:** Beyond Service Life  
**Category:** Deferred Maintenance  
**Priority:** 3 - Necessary/Not Yet Critical (Years 2-5)  
**Correction:** Renew System  
**Qty:** 34,888.00  
**Unit of Measure:** S.F.  
**Estimate:** \$508,109.00  
**Assessor Name:** Eduardo Lopez  
**Date Created:** 01/04/2017

**Notes:** The original flooring is in poor conditions and should be replaced.

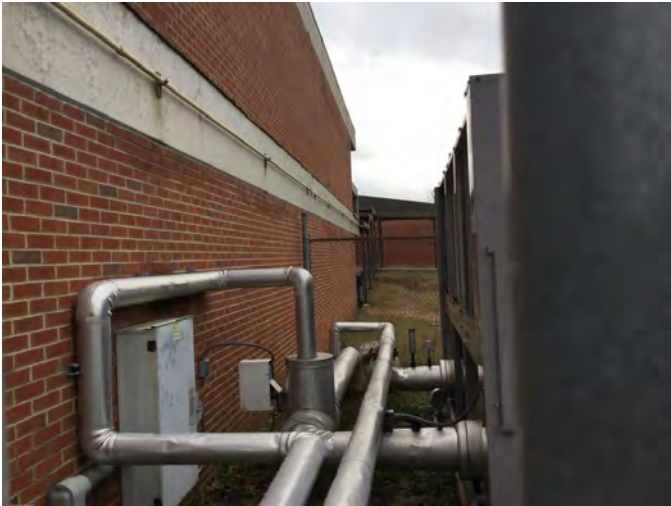
**System: D3040 - Distribution Systems**

**Location:** Throughout the Building  
**Distress:** Beyond Service Life  
**Category:** Deferred Maintenance  
**Priority:** 3 - Necessary/Not Yet Critical (Years 2-5)  
**Correction:** Renew System  
**Qty:** 34,888.00  
**Unit of Measure:** S.F.  
**Estimate:** \$388,373.00  
**Assessor Name:** Eduardo Lopez  
**Date Created:** 01/04/2017

**Notes:** Distribution systems are aged, becoming logistically unsupportable, and should be replaced.

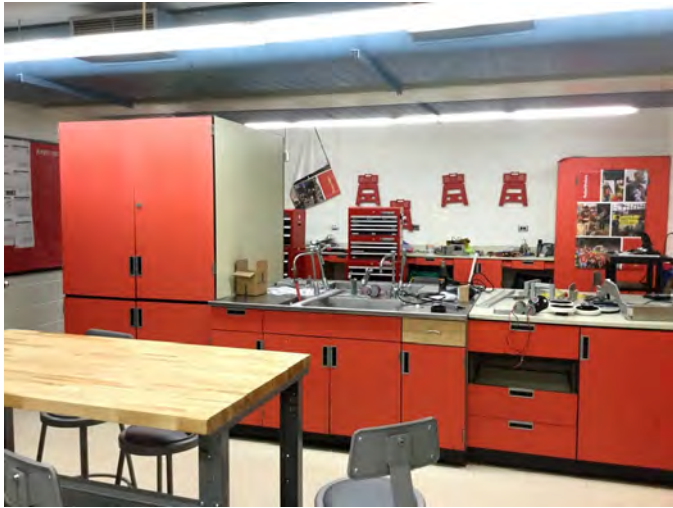
**System: E2010 - Fixed Furnishings**

**Location:** Throughout the Building  
**Distress:** Beyond Service Life  
**Category:** Deferred Maintenance  
**Priority:** 3 - Necessary/Not Yet Critical (Years 2-5)  
**Correction:** Renew System  
**Qty:** 34,888.00  
**Unit of Measure:** S.F.  
**Estimate:** \$231,412.00  
**Assessor Name:** Eduardo Lopez  
**Date Created:** 01/04/2017

**Notes:** The fixed furnishings are aged, in marginal condition, and should be replaced.

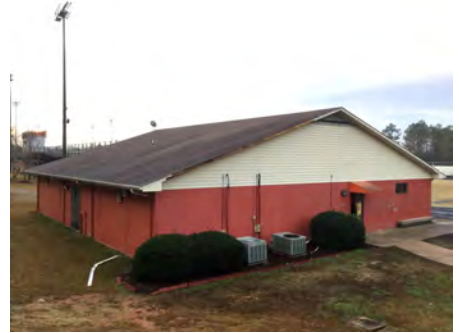
3). North Elevation - Feb 12, 2017

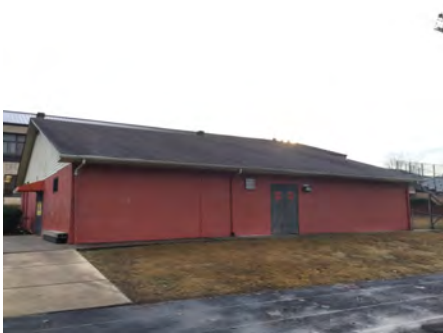
4). West Elevation - Feb 12, 2017

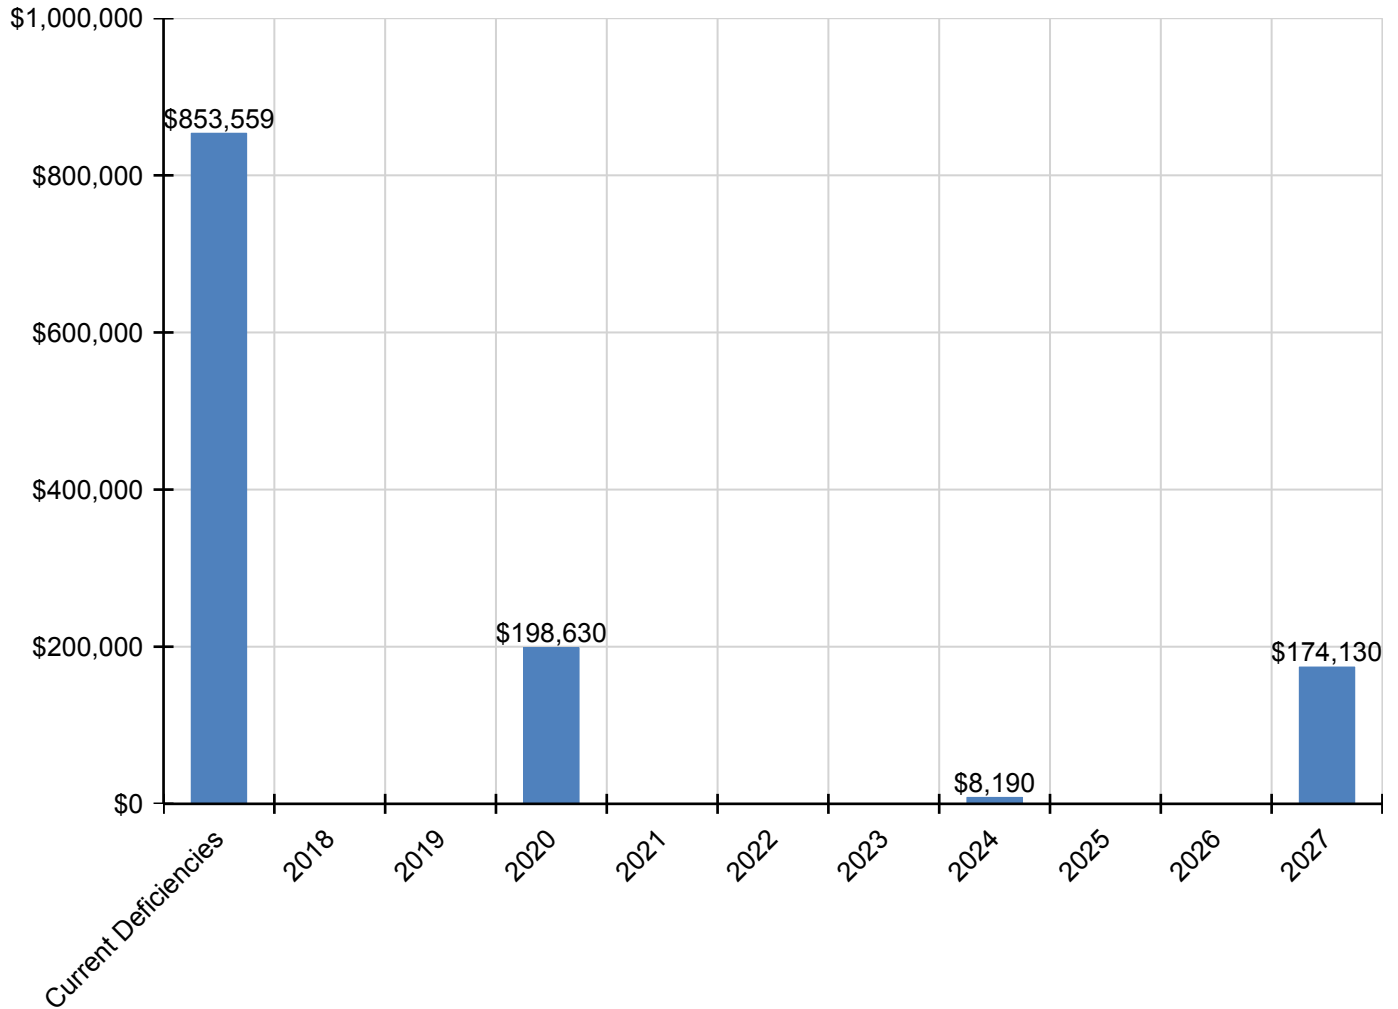
## Forecasted Capital Renewal Requirement

The following chart shows the current building deficiencies and forecasting capital renewal or sustainment requirements over the next ten years.

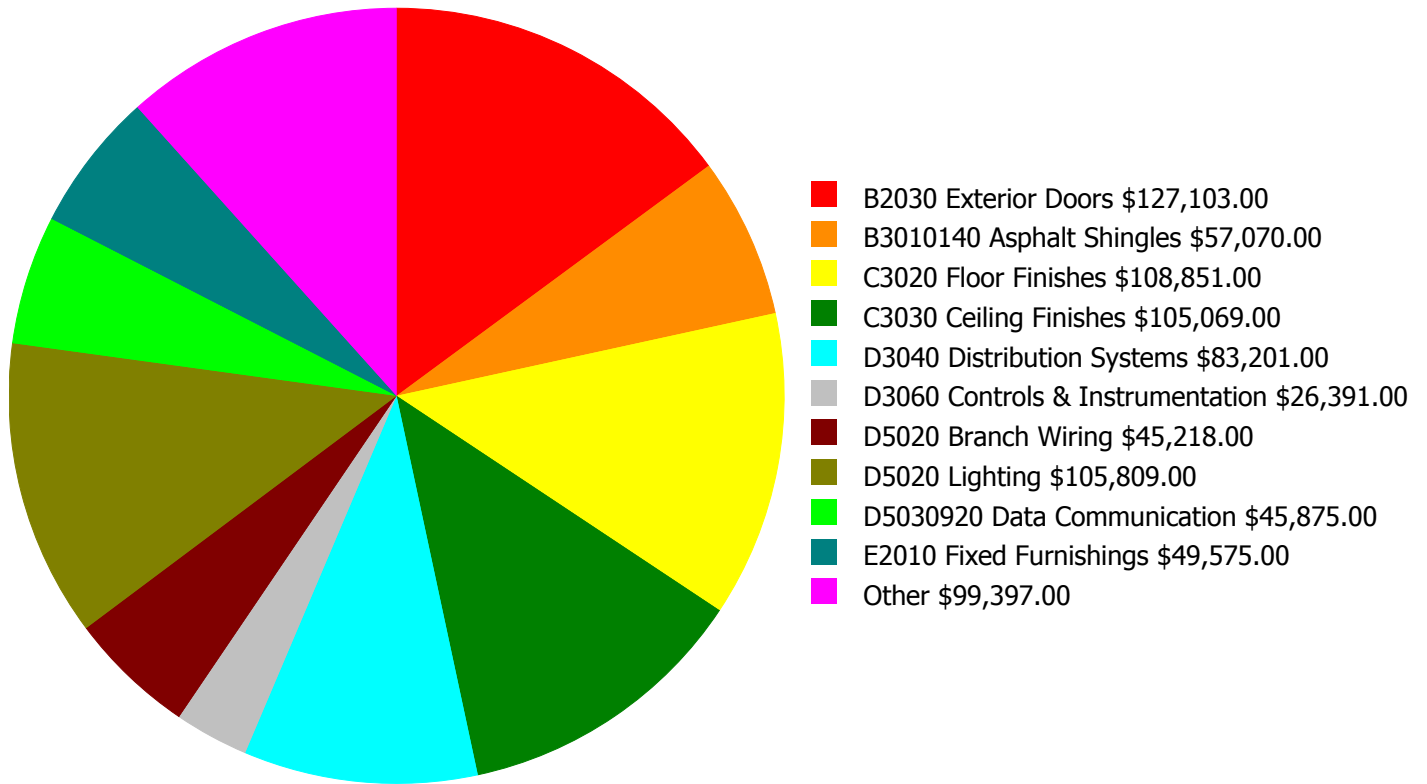
### Deficiency Summary by System

Current deficiencies included assemblies that have reached or exceeded their design life or components of the assemblies that are in need of repair. Assemblies that have reached their design life are identified as current deficiencies and assigned the distress 'Beyond Useful Life'. The following chart lists all current deficiencies associated with this facility.

**Budget Estimate Total: \$853,559.00**

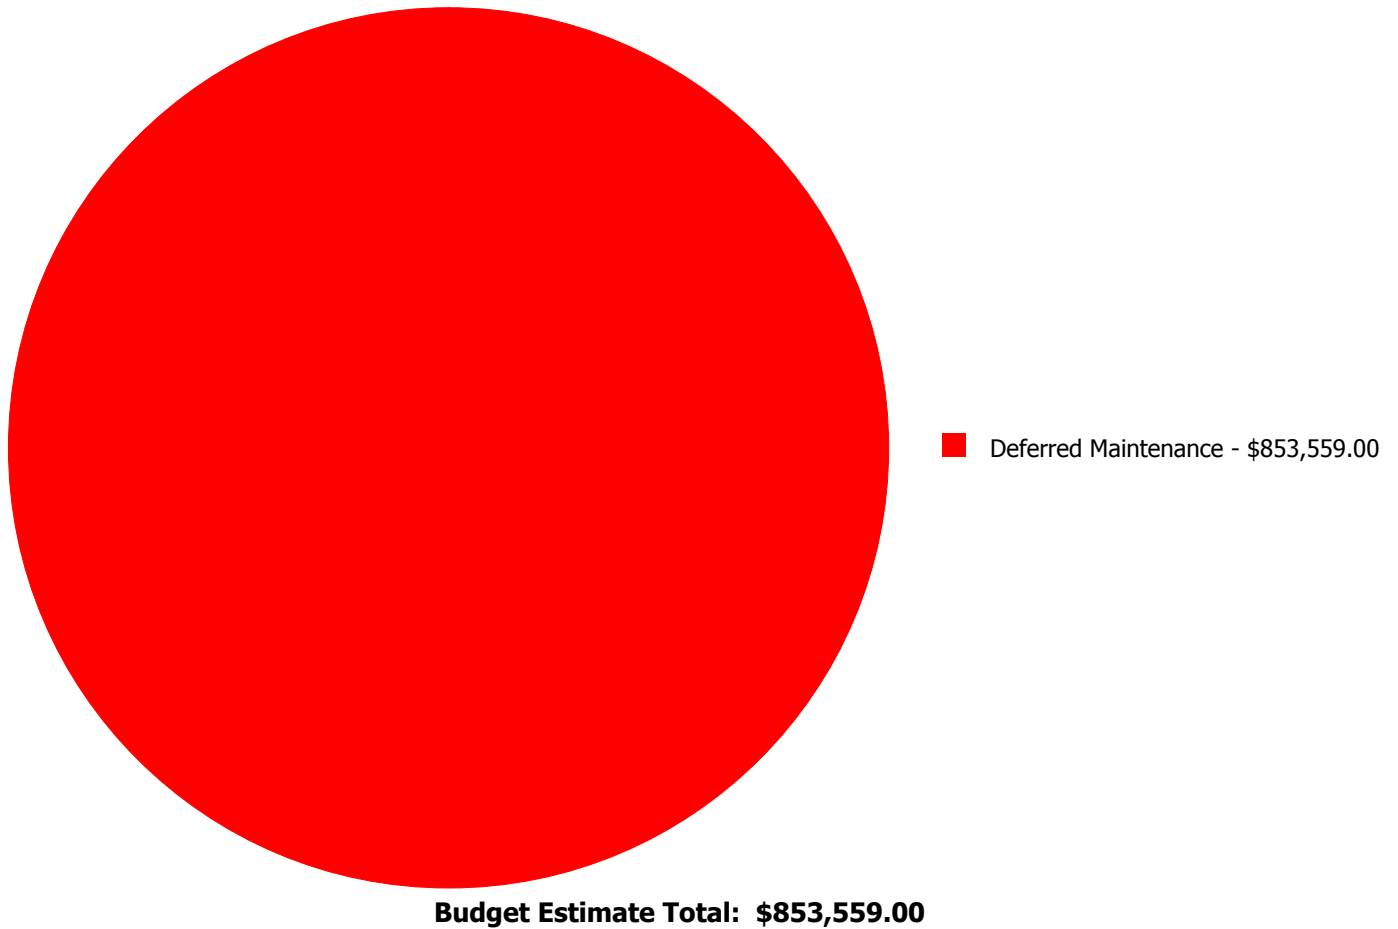
## Deficiency Summary by Category

The following chart shows the total repair costs broken down by deficiency categories. Assessors assigned deficiencies to one of the following categories:

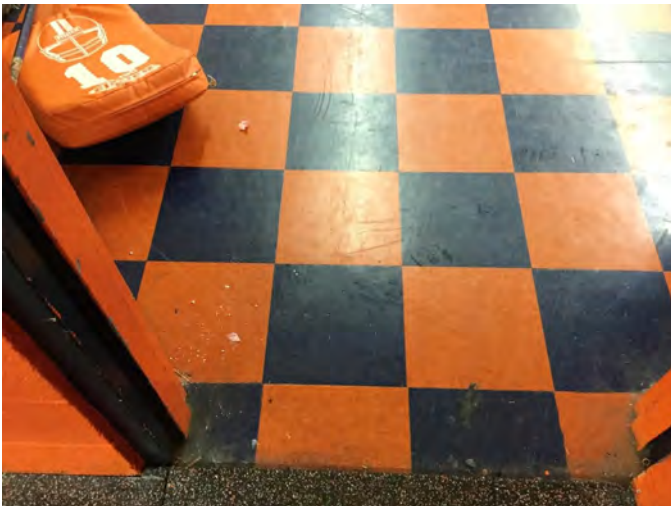
**System: C3020 - Floor Finishes**

**Location:** Throughout the Building  
**Distress:** Beyond Service Life  
**Category:** Deferred Maintenance  
**Priority:** 3 - Necessary/Not Yet Critical (Years 2-5)  
**Correction:** Renew System  
**Qty:** 7,474.00  
**Unit of Measure:** S.F.  
**Estimate:** \$108,851.00  
**Assessor Name:** Eduardo Lopez  
**Date Created:** 01/04/2017

**Notes:** The original flooring is in poor conditions and should be replaced.

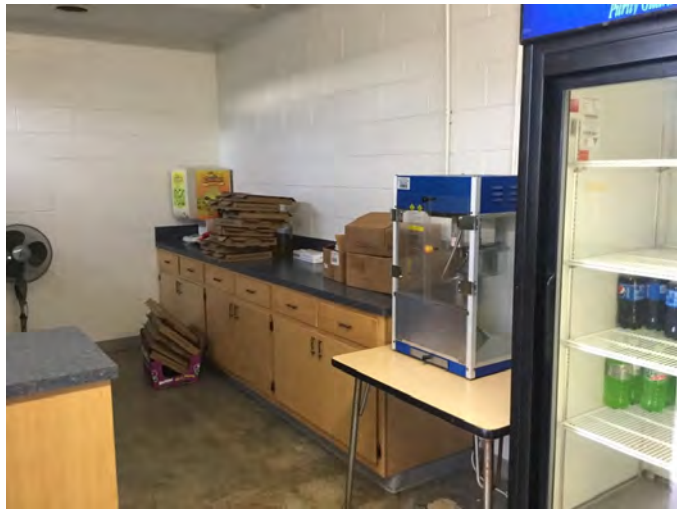
**System: E2010 - Fixed Furnishings**

**Location:** Throughout the Building  
**Distress:** Beyond Service Life  
**Category:** Deferred Maintenance  
**Priority:** 3 - Necessary/Not Yet Critical (Years 2-5)  
**Correction:** Renew System  
**Qty:** 7,474.00  
**Unit of Measure:** S.F.  
**Estimate:** \$49,575.00  
**Assessor Name:** Eduardo Lopez  
**Date Created:** 02/15/2017

**Notes:** The fixed furnishings are aged, in marginal condition, and should be replaced.

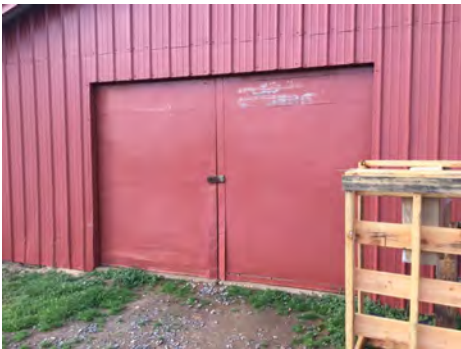
**System:** B2030 - Exterior Doors

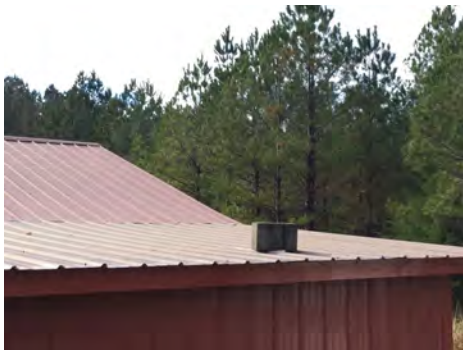
**System:** B3010130 - Preformed Metal Roofing

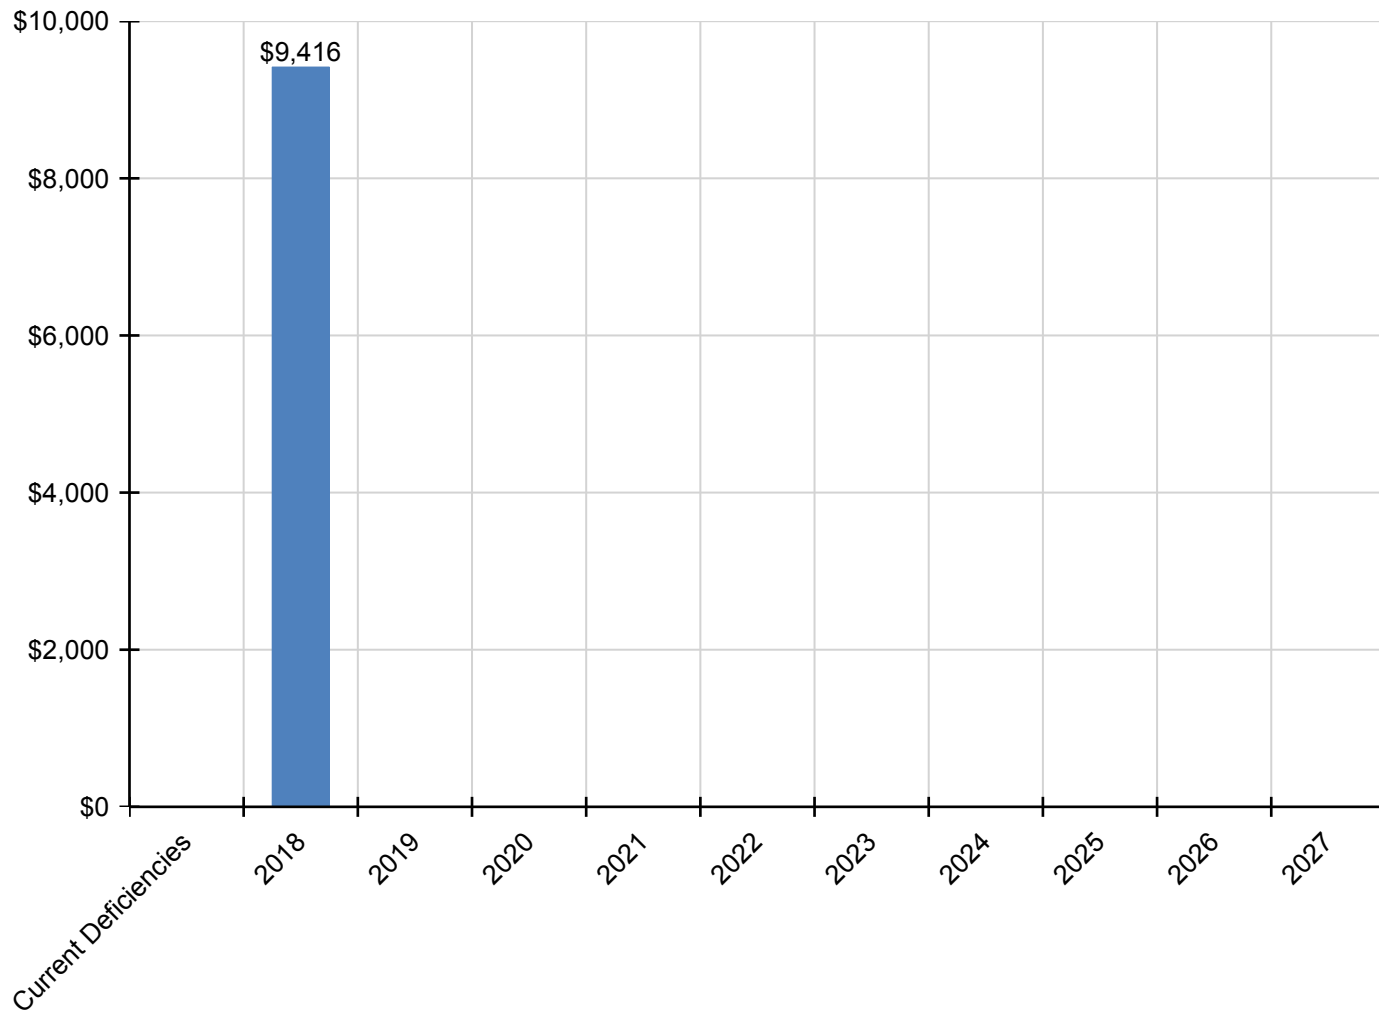
### Forecasted Capital Renewal Requirement

The following chart shows the current building deficiencies and forecasting capital renewal or sustainment requirements over the next ten years.

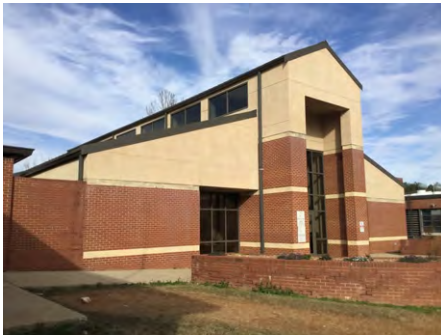
1). South Elevation - Feb 16, 2017

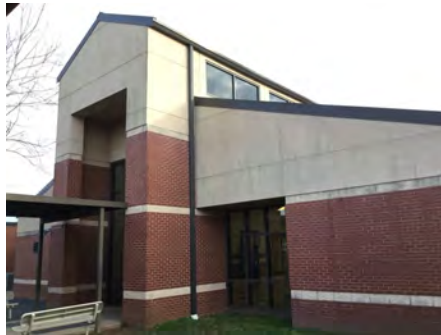
2). North Elevation - Feb 16, 2017

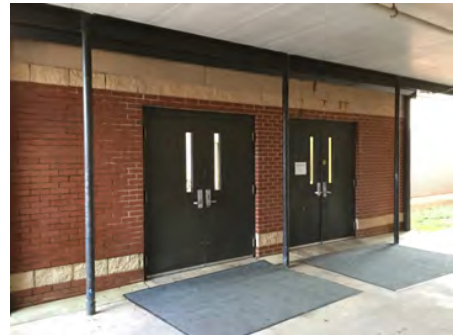
3). West Elevation - Feb 16, 2017

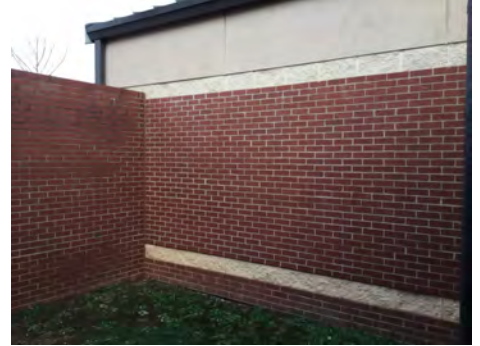
**System:** B2010 - Exterior Walls

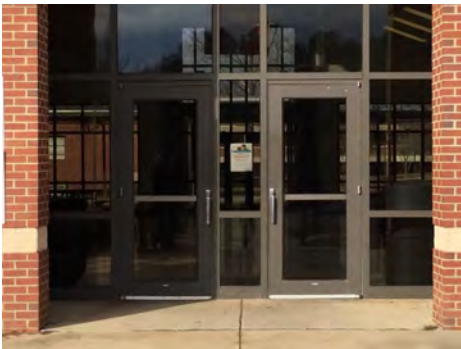
**System:** B2030 - Exterior Doors

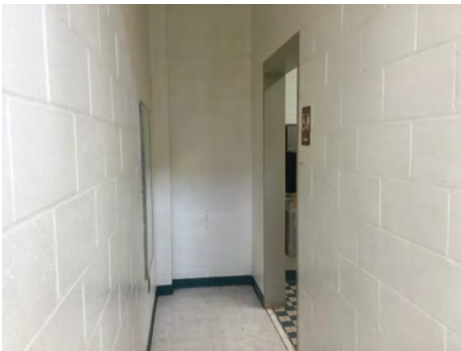
**System:** C1010 - Partitions

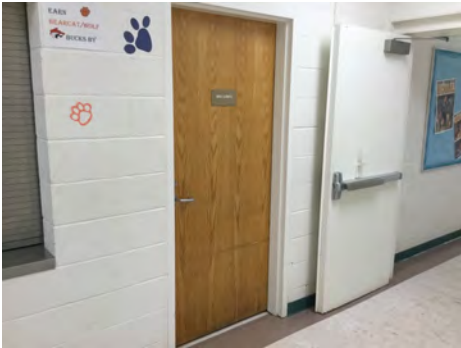
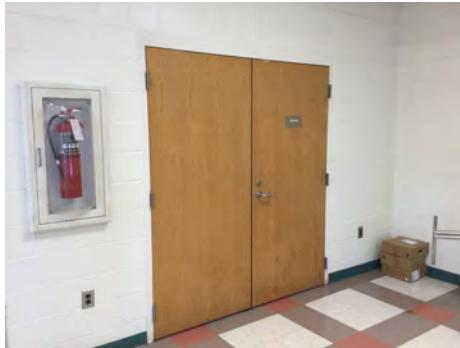
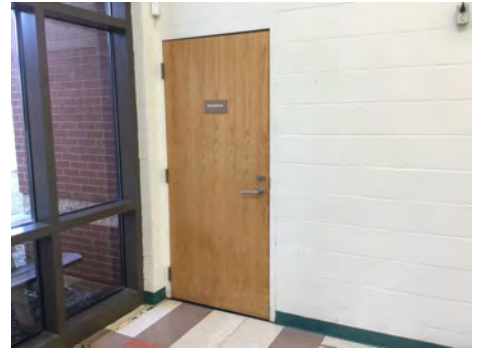
**System:** C1020 - Interior Doors

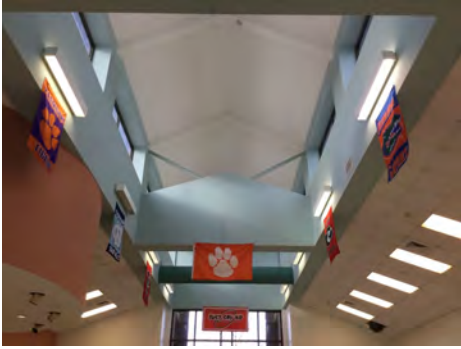
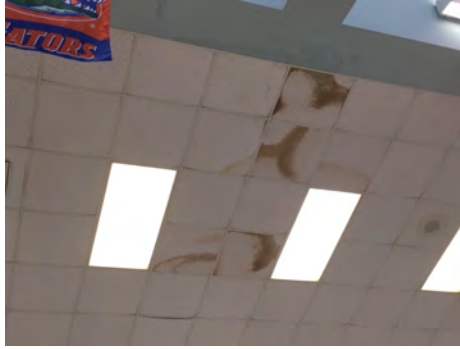
**System:** C3030 - Ceiling Finishes

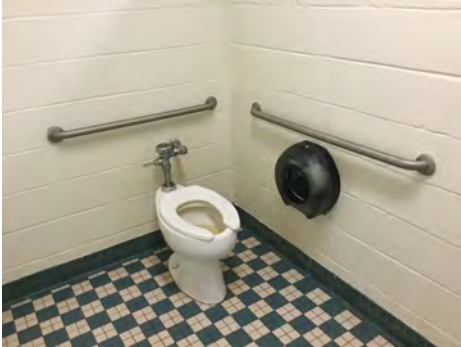
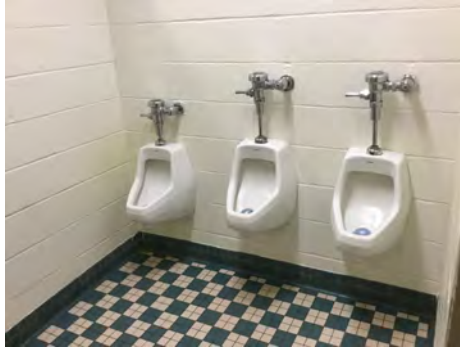
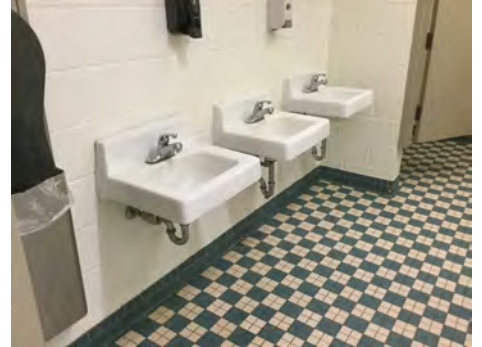
**System:** D2010 - Plumbing Fixtures

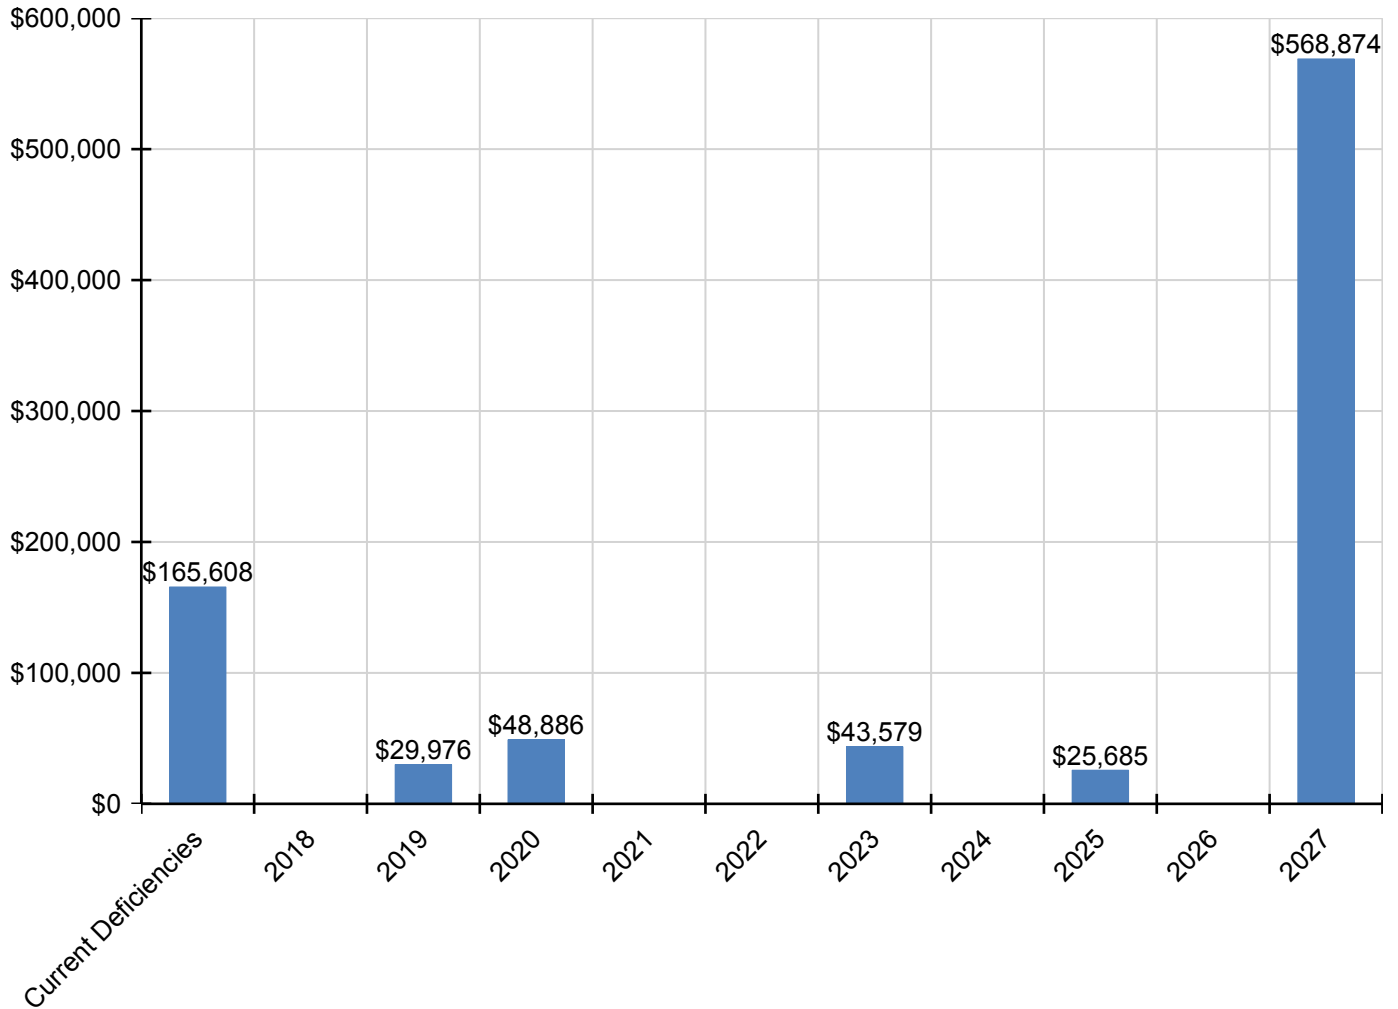
## Forecasted Capital Renewal Requirement

The following chart shows the current building deficiencies and forecasting capital renewal or sustainment requirements over the next ten years.

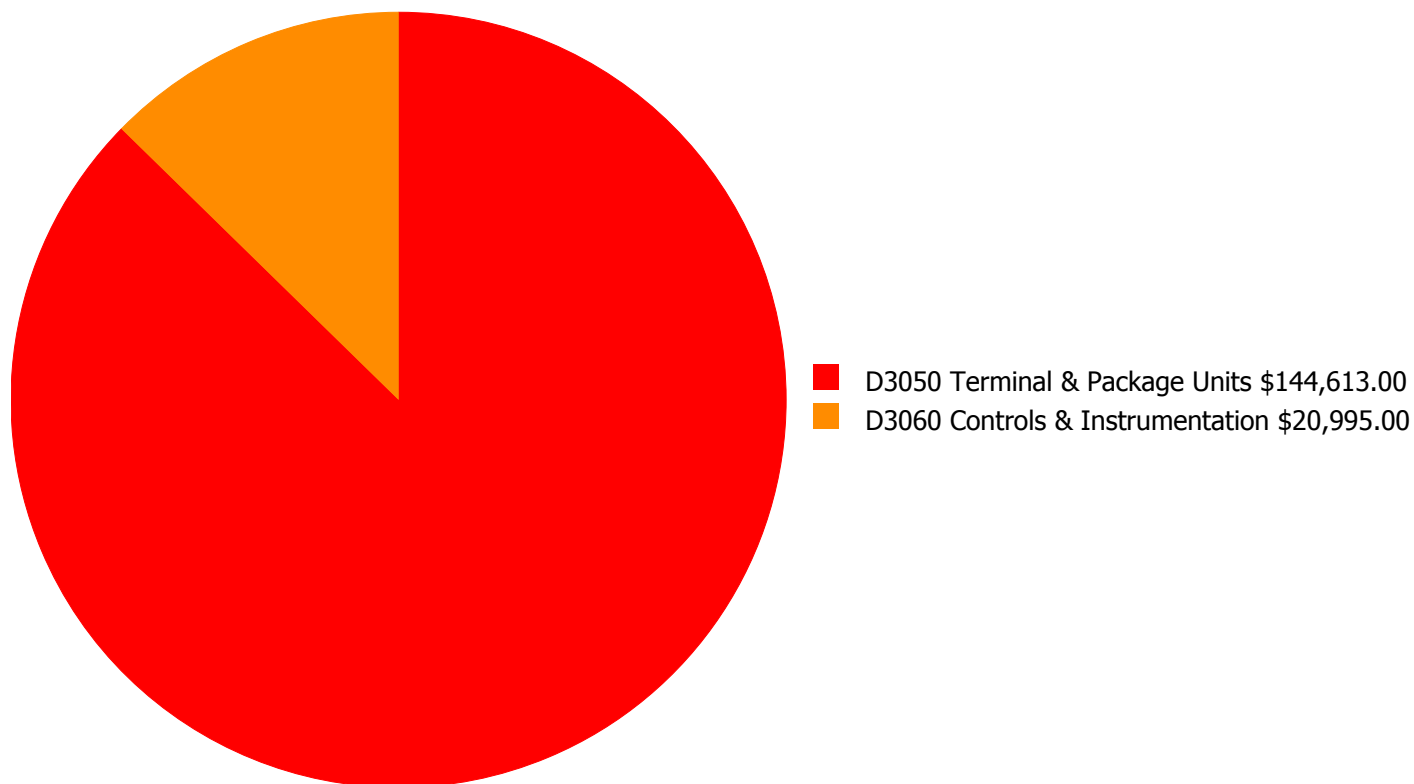
## Deficiency Summary by System

Current deficiencies included assemblies that have reached or exceeded their design life or components of the assemblies that are in need of repair. Assemblies that have reached their design life are identified as current deficiencies and assigned the distress 'Beyond Useful Life'. The following chart lists all current deficiencies associated with this facility.

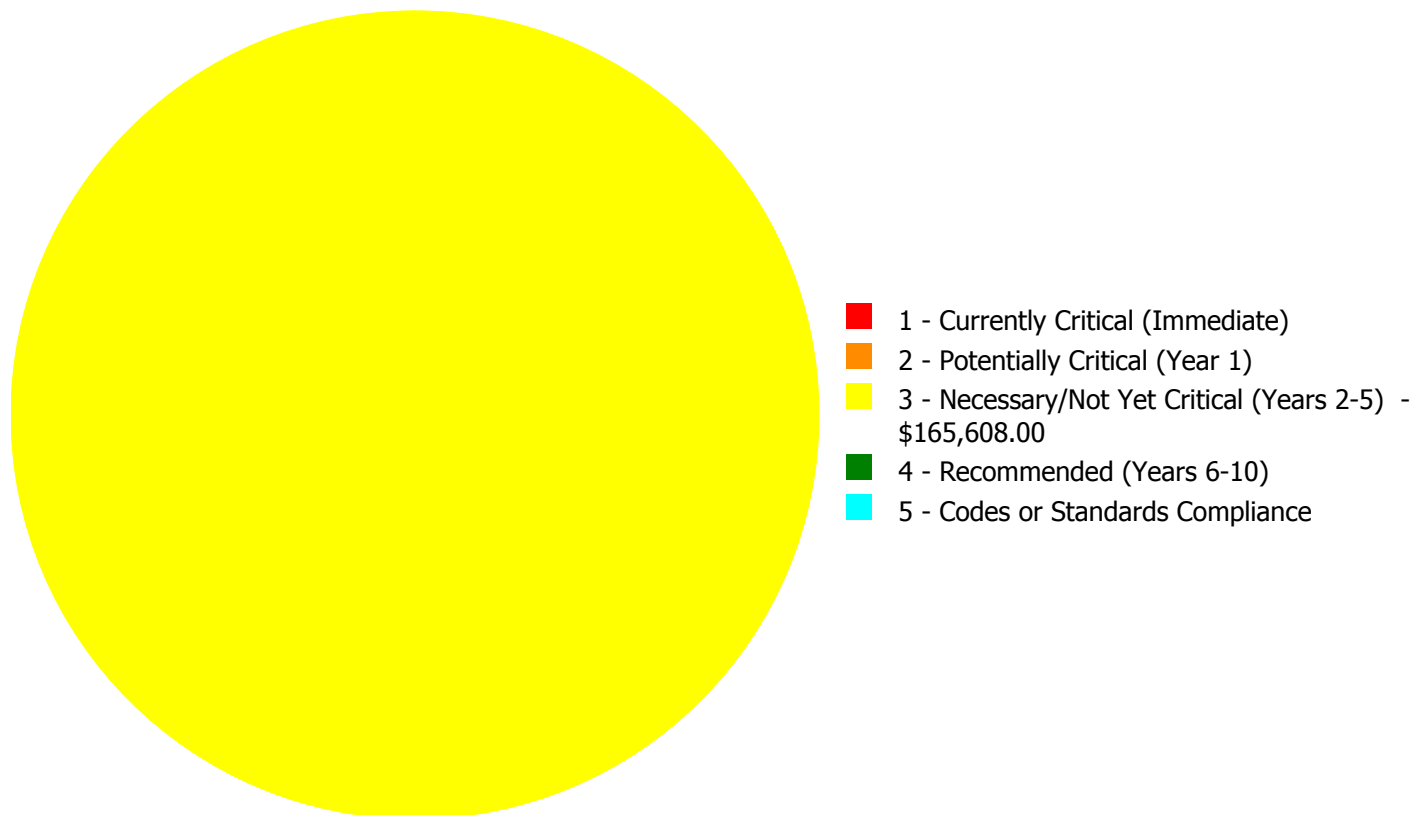
## Deficiency Summary by Priority

The following chart shows the total repair costs broken down by priority. Assessors assigned deficiencies within eCOMET to one of the following priority categories:

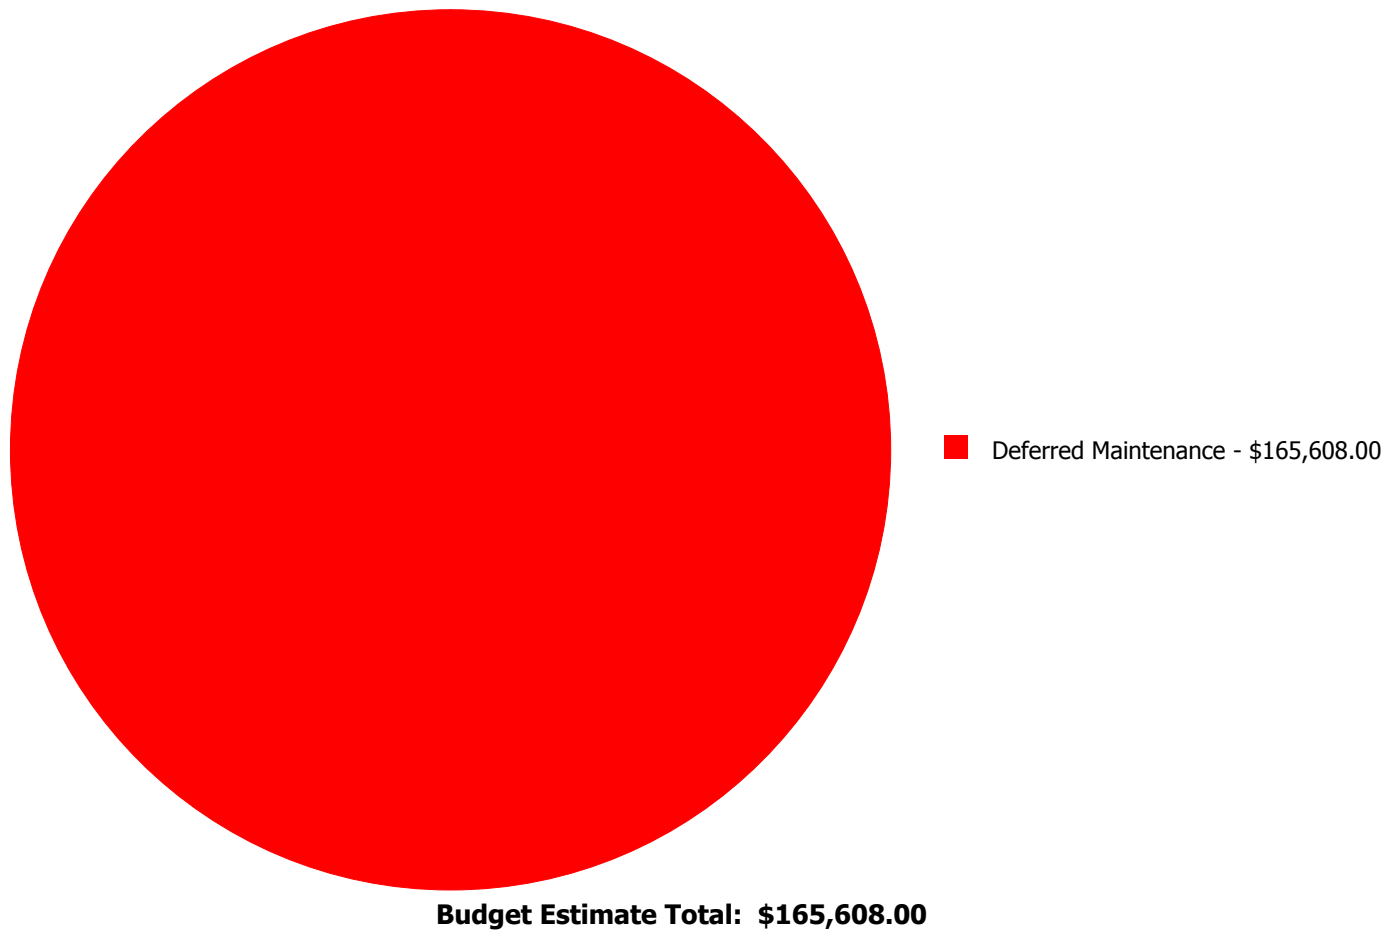
## Deficiency Summary by Category

The following chart shows the total repair costs broken down by deficiency categories. Assessors assigned deficiencies to one of the following categories:

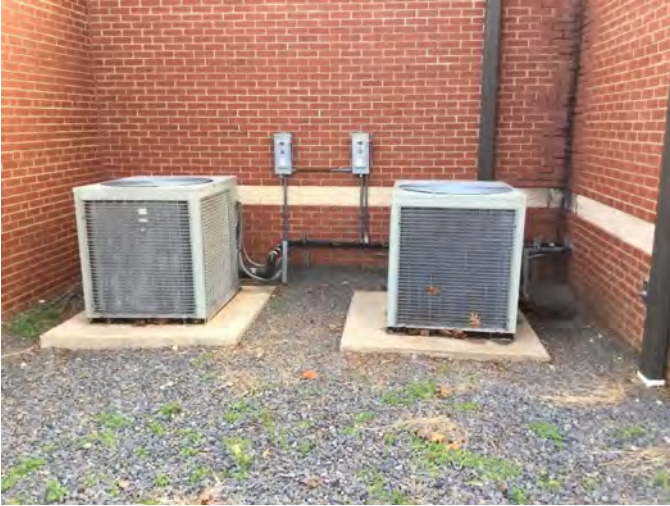
#### System: D3050 - Terminal & Package Units

**Location:** Throughout the Building  
**Distress:** Beyond Service Life  
**Category:** Deferred Maintenance  
**Priority:** 3 - Necessary/Not Yet Critical (Years 2-5)  
**Correction:** Renew System  
**Qty:** 5,946.00  
**Unit of Measure:** S.F.  
**Estimate:** \$144,613.00  
**Assessor Name:** Eduardo Lopez  
**Date Created:** 02/16/2017

**Notes:** Terminal and package units are beyond their expected service life and should be scheduled for replacement.

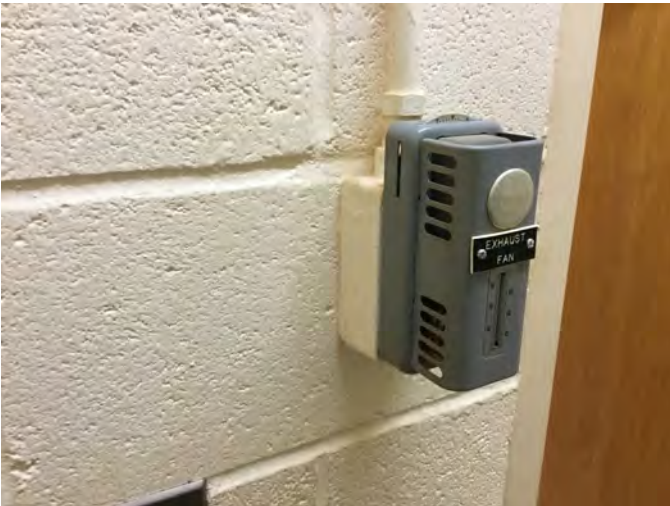
#### System: D3060 - Controls & Instrumentation

**Location:** Throughout the Building  
**Distress:** Beyond Service Life  
**Category:** Deferred Maintenance  
**Priority:** 3 - Necessary/Not Yet Critical (Years 2-5)  
**Correction:** Renew System  
**Qty:** 5,946.00  
**Unit of Measure:** S.F.  
**Estimate:** \$20,995.00  
**Assessor Name:** Eduardo Lopez  
**Date Created:** 02/16/2017

**Notes:** The controls and instrumentation system is in marginal condition and should be schedule for replacement.

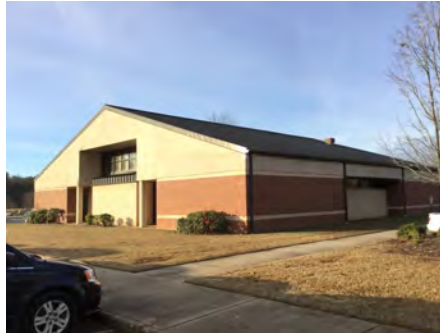
2). Northeast Elevation - Feb 12, 2017

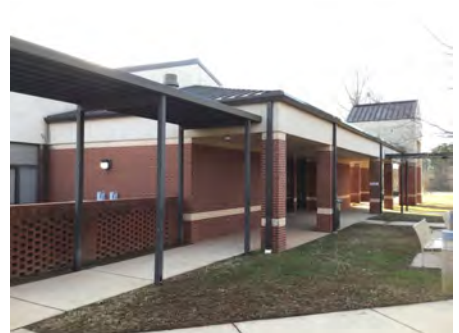
3). West Elevation - Feb 12, 2017

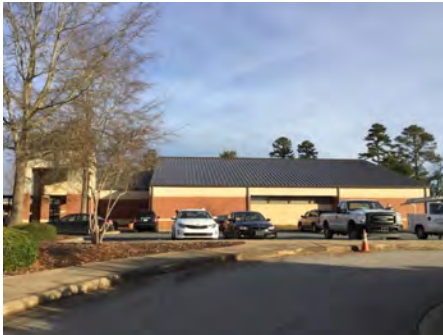
4). South Elevation - Feb 12, 2017

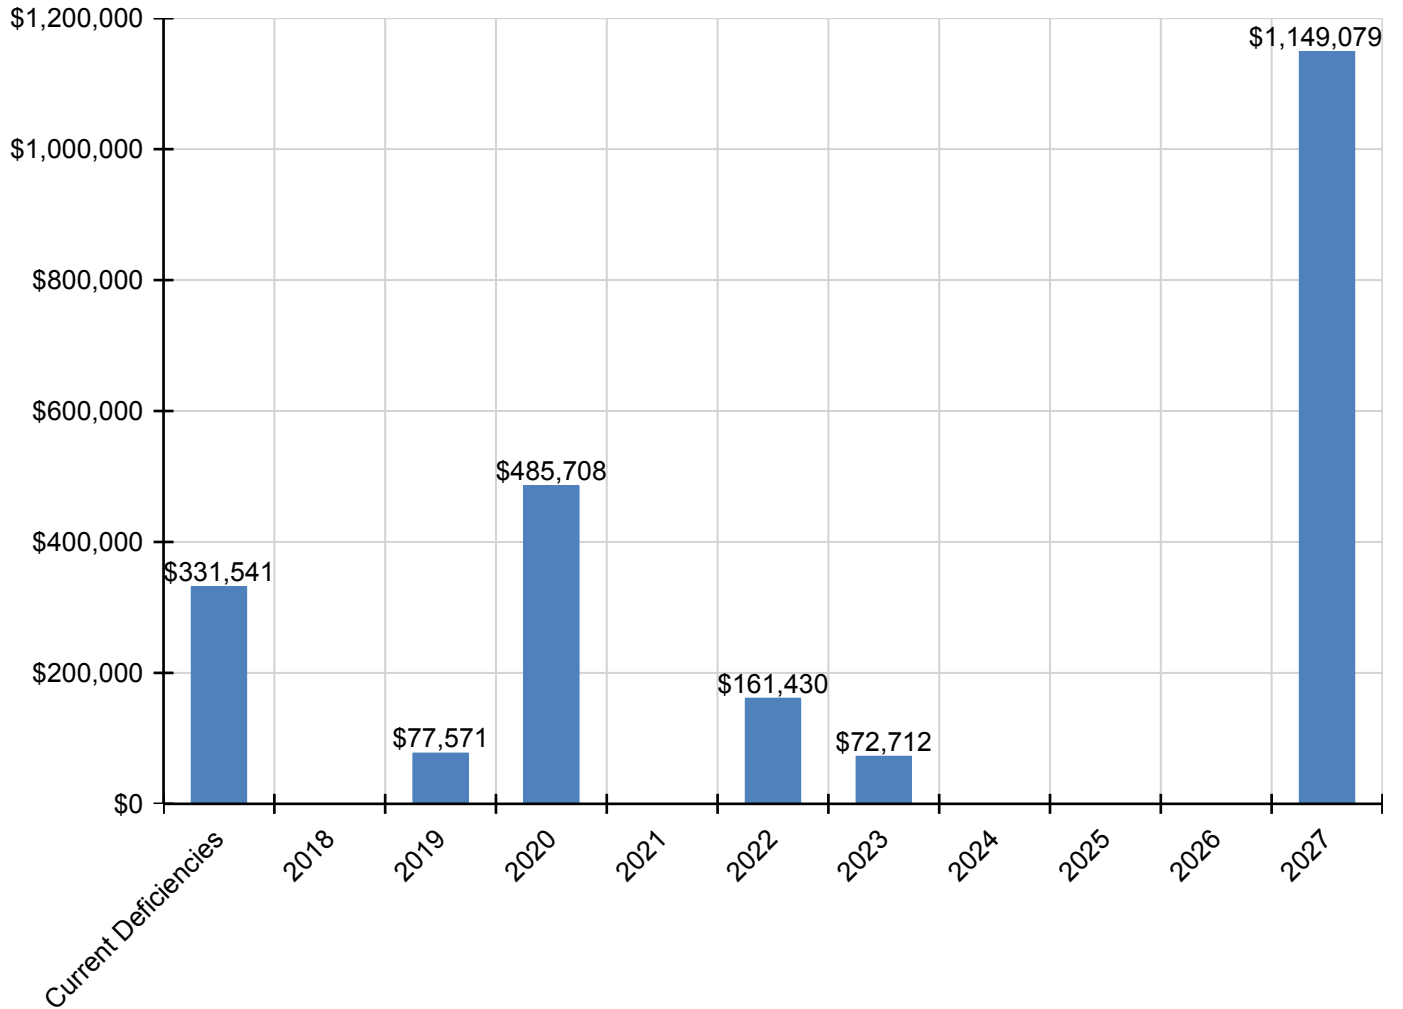
## Forecasted Capital Renewal Requirement

The following chart shows the current building deficiencies and forecasting capital renewal or sustainment requirements over the next ten years.

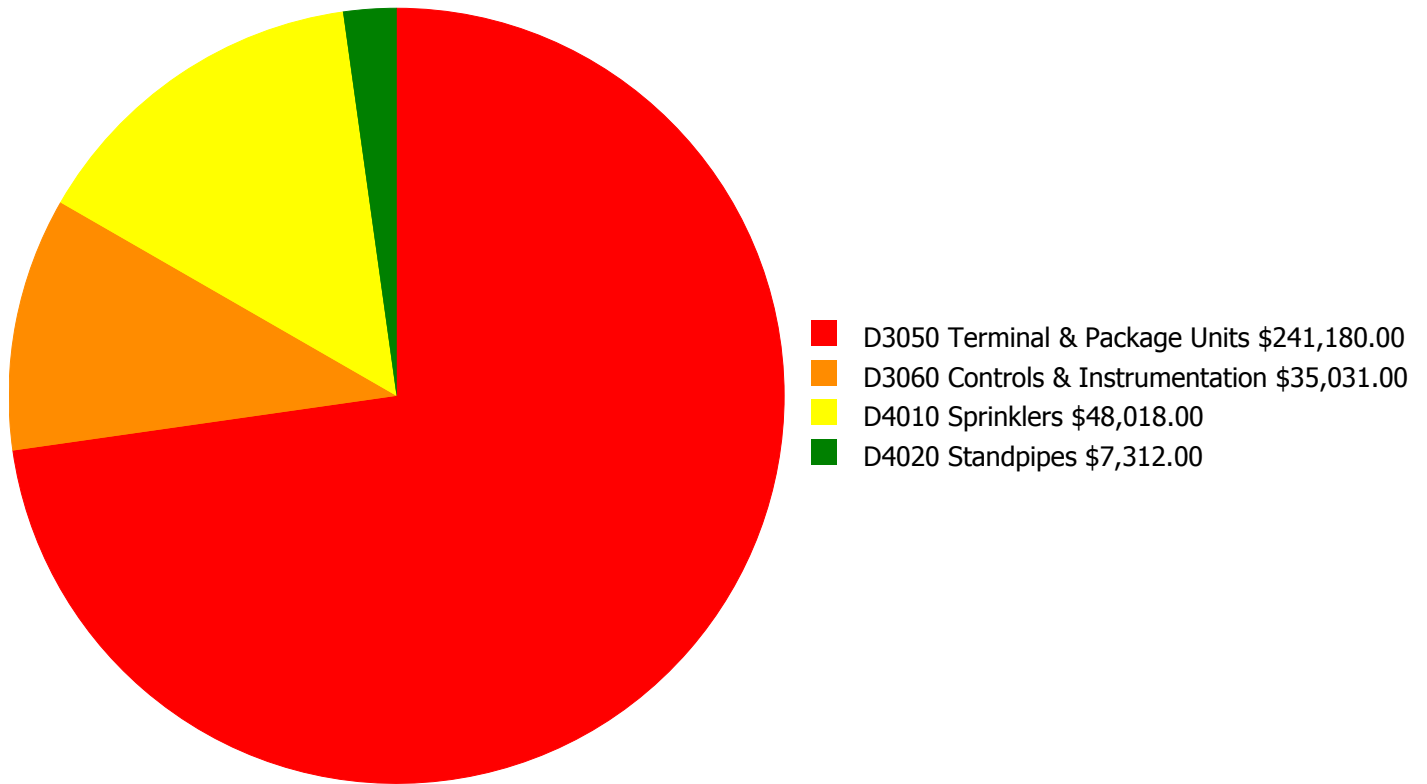
## Deficiency Summary by System

Current deficiencies included assemblies that have reached or exceeded their design life or components of the assemblies that are in need of repair. Assemblies that have reached their design life are identified as current deficiencies and assigned the distress 'Beyond Useful Life'. The following chart lists all current deficiencies associated with this facility.

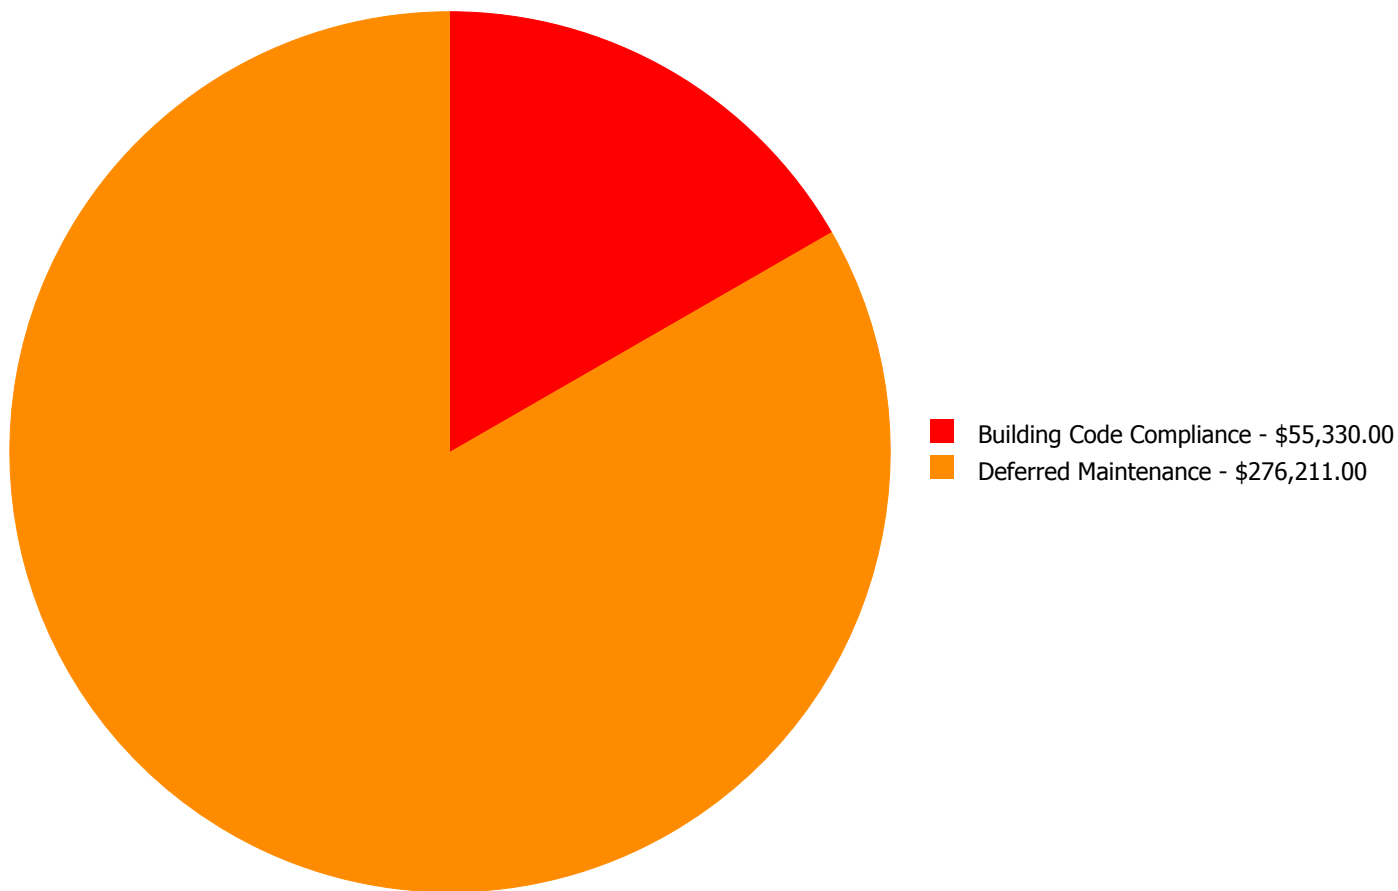
### Deficiency Summary by Category

The following chart shows the total repair costs broken down by deficiency categories. Assessors assigned deficiencies to one of the following categories:

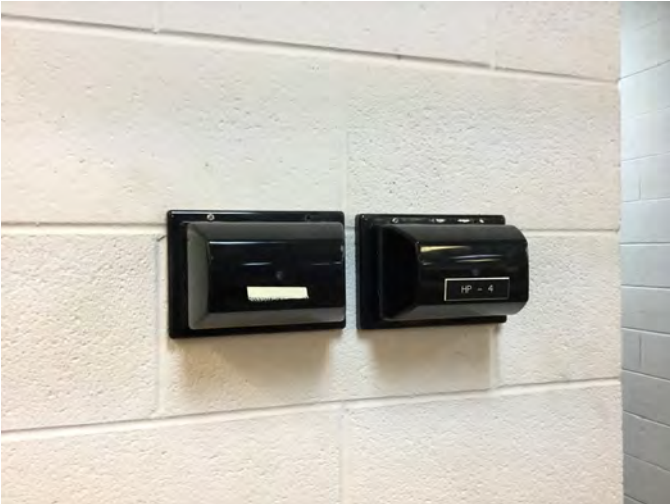
#### System: D3060 - Controls & Instrumentation

**Location:** Throughout the Building  
**Distress:** Beyond Service Life  
**Category:** Deferred Maintenance  
**Priority:** 3 - Necessary/Not Yet Critical (Years 2-5)  
**Correction:** Renew System  
**Qty:** 9,921.00  
**Unit of Measure:** S.F.  
**Estimate:** \$35,031.00  
**Assessor Name:** Eduardo Lopez  
**Date Created:** 01/04/2017

**Notes:** The controls and instrumentation system is in marginal condition and should be schedule for replacement.
