# Anson Middle

## Campus Assessment Report

March 7, 2017

## Campus Assessment Report - 1966 Building, Cafe/Gym

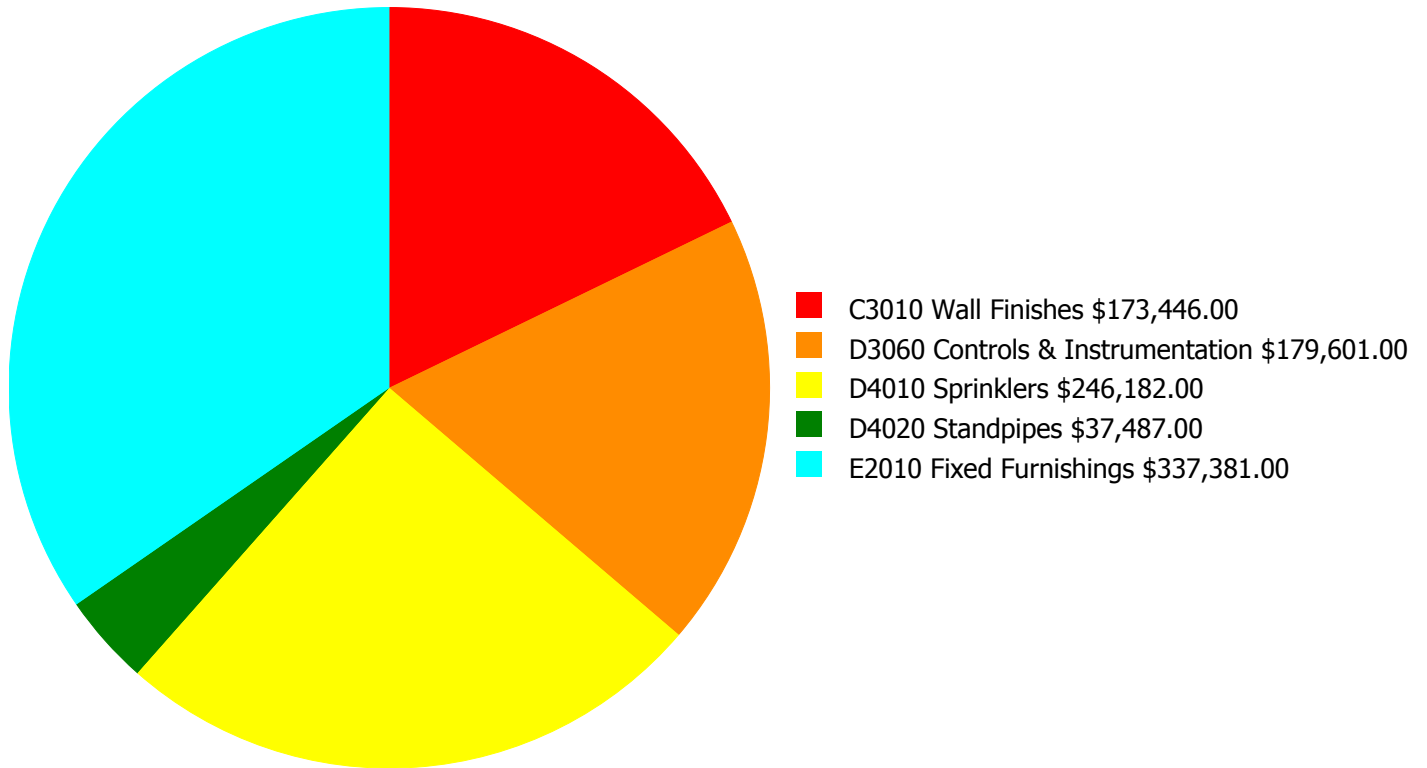
## Deficiency Summary by System

Current deficiencies included assemblies that have reached or exceeded their design life or components of the assemblies that are in need of repair. Assemblies that have reached their design life are identified as current deficiencies and assigned the distress 'Beyond Useful Life'. The following chart lists all current deficiencies associated with this facility.

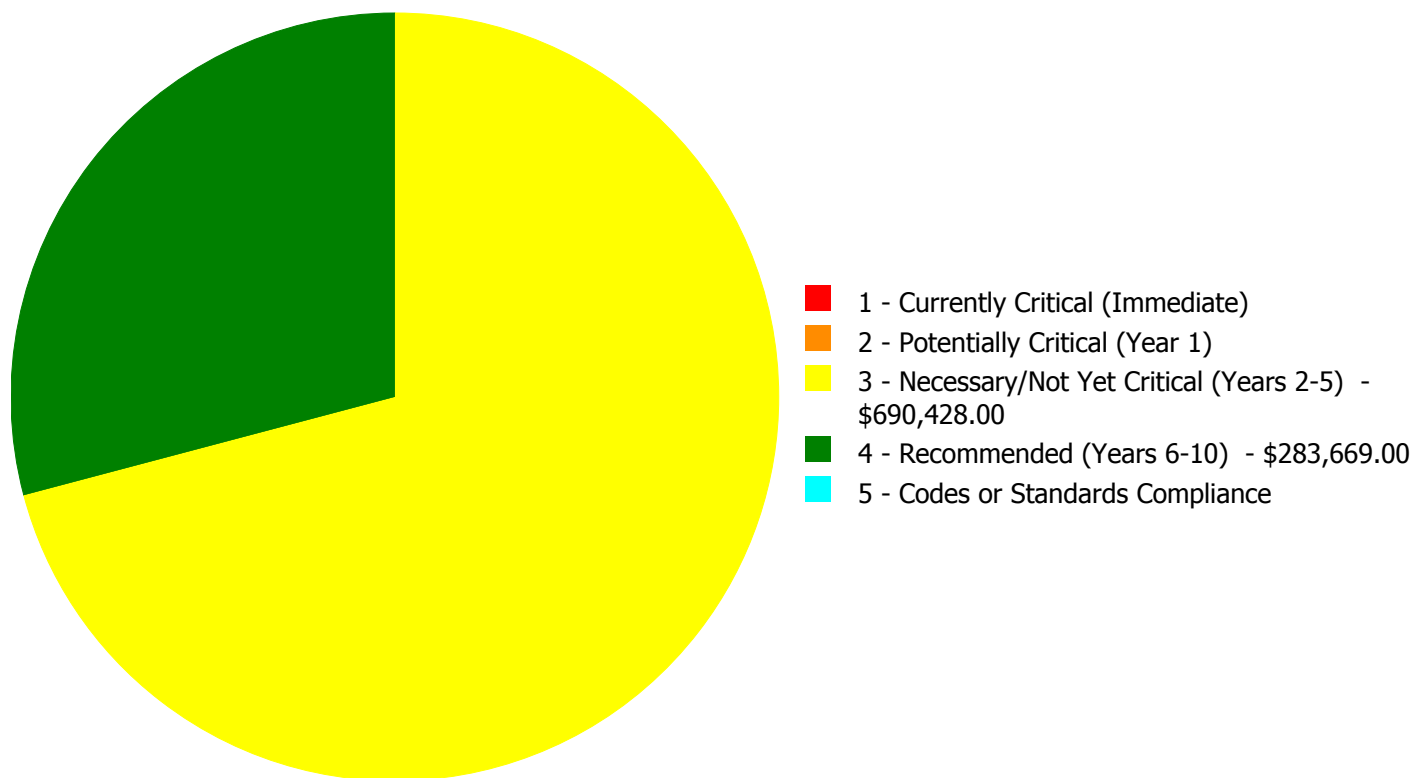
### Deficiency Summary by Priority

The following chart shows the total repair costs broken down by priority. Assessors assigned deficiencies within eCOMET to one of the following priority categories:

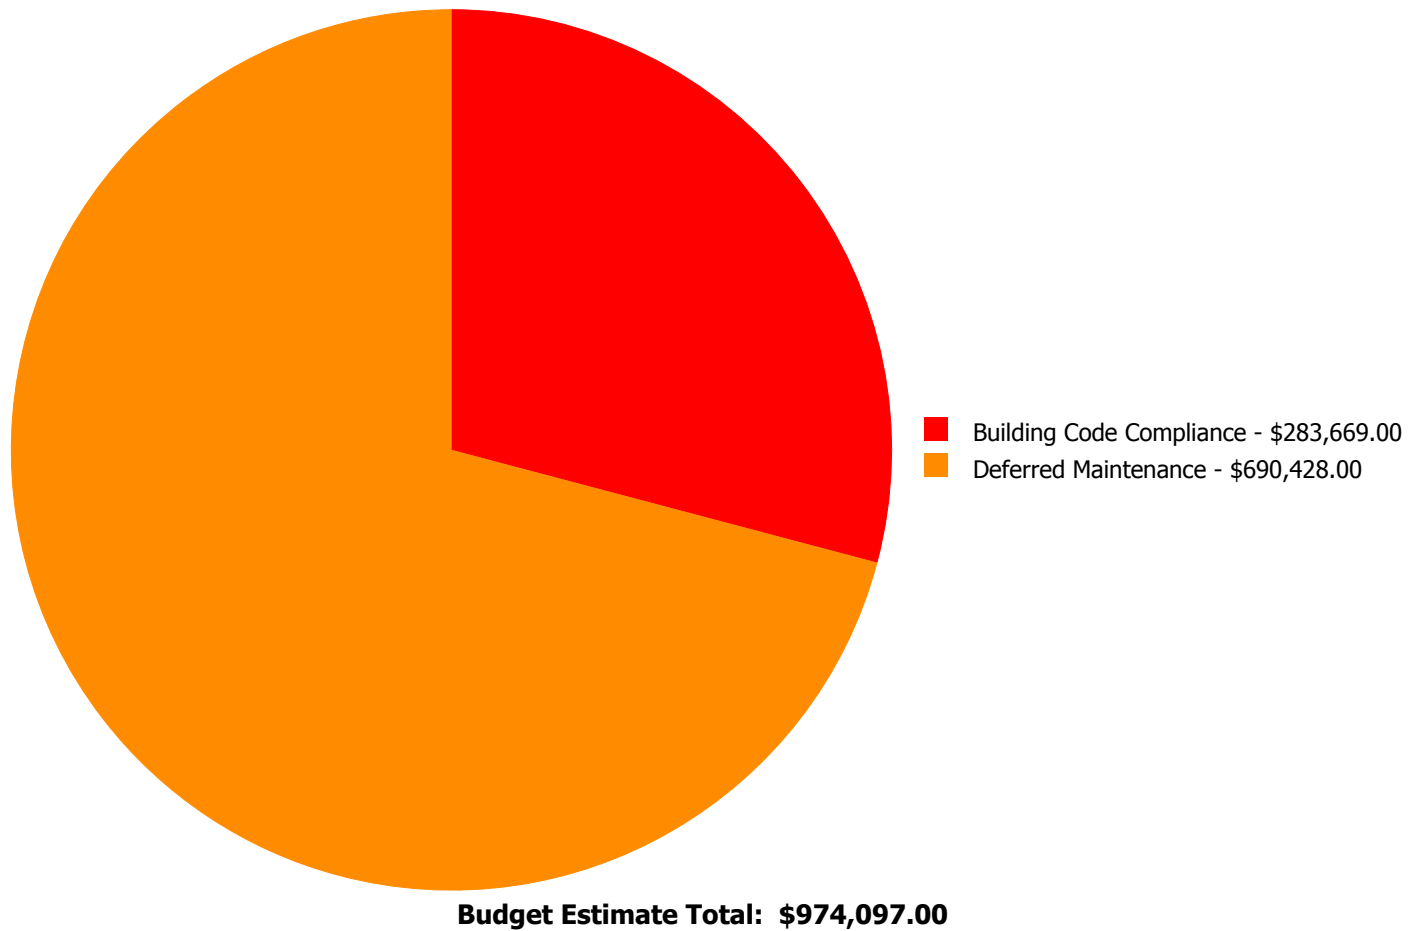
## Deficiency Summary by Category

The following chart shows the total repair costs broken down by deficiency categories. Assessors assigned deficiencies to one of the following categories:

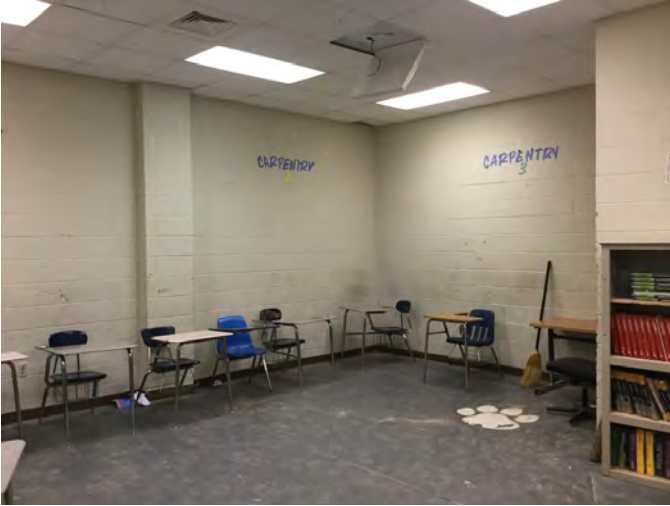
#### System: C3010 - Wall Finishes

**Location:** Throughout the Building  
**Distress:** Beyond Service Life  
**Category:** Deferred Maintenance  
**Priority:** 3 - Necessary/Not Yet Critical (Years 2-5)  
**Correction:** Renew System  
**Qty:** 50,864.00  
**Unit of Measure:** S.F.  
**Estimate:** \$173,446.00  
**Assessor Name:** Eduardo Lopez  
**Date Created:** 01/04/2017

**Notes:** The wall finishes are aged, scuffed, fading, stained and should be replaced.

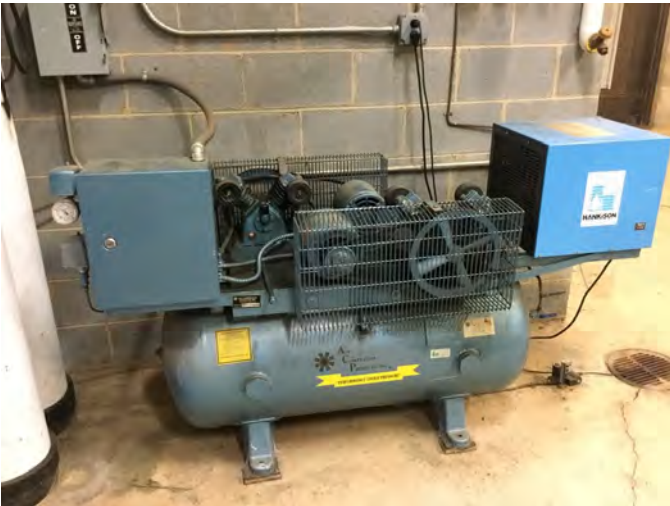
#### System: D3060 - Controls & Instrumentation

**Location:** Throughout the Building  
**Distress:** Beyond Service Life  
**Category:** Deferred Maintenance  
**Priority:** 3 - Necessary/Not Yet Critical (Years 2-5)  
**Correction:** Renew System  
**Qty:** 50,864.00  
**Unit of Measure:** S.F.  
**Estimate:** \$179,601.00  
**Assessor Name:** Eduardo Lopez  
**Date Created:** 01/04/2017

**Notes:** The controls and instrumentation system is in marginal condition and should be schedule for replacement.

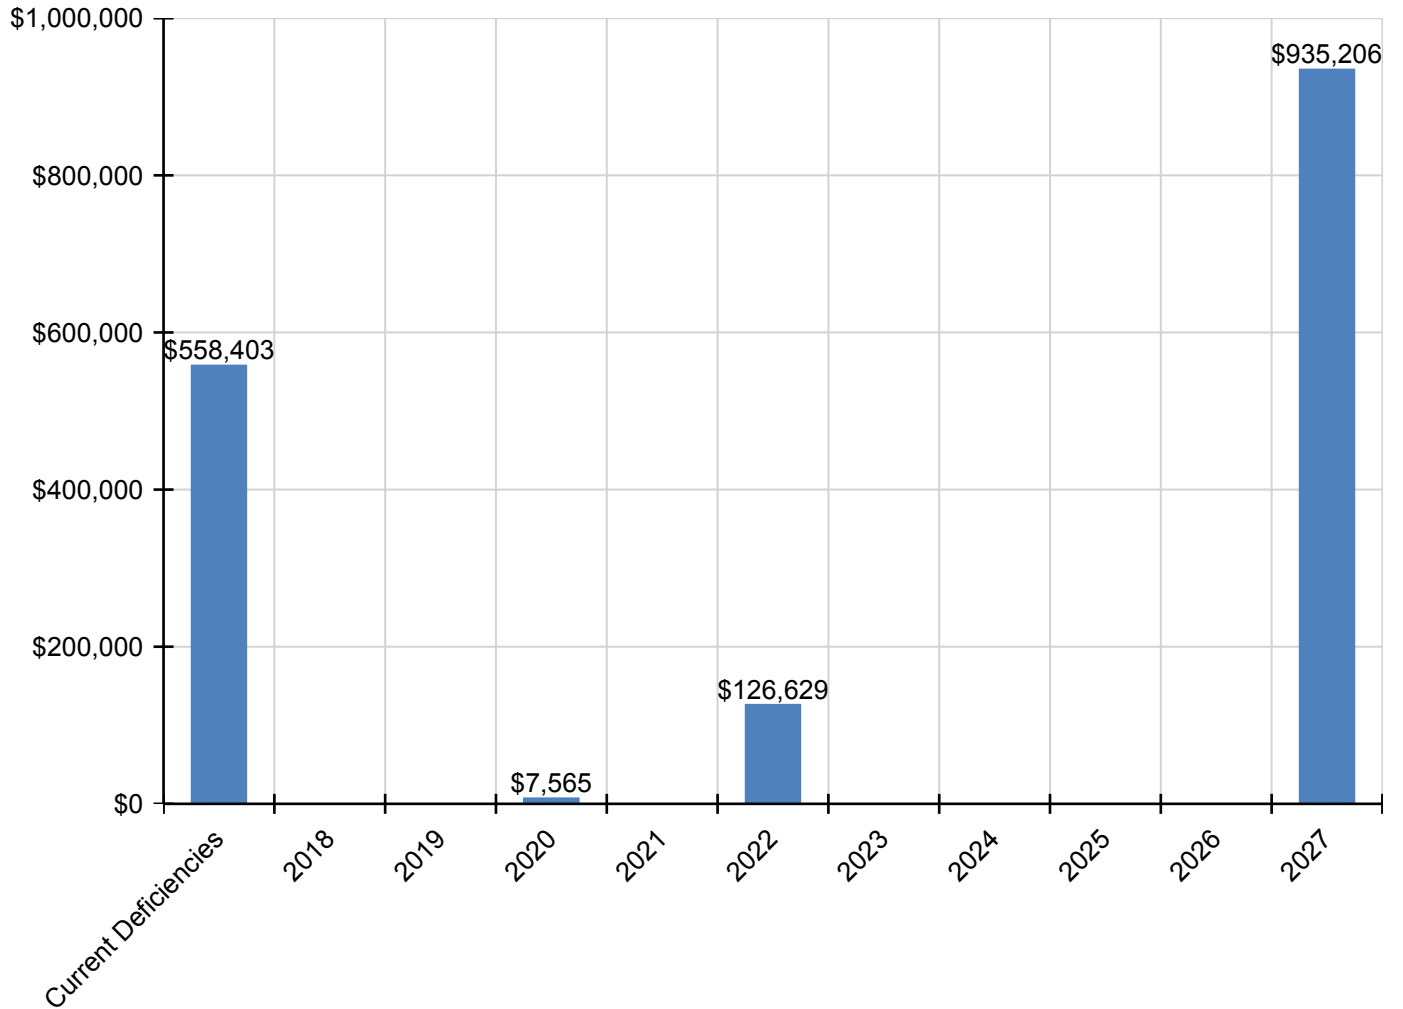
## Forecasted Capital Renewal Requirement

The following chart shows the current building deficiencies and forecasting capital renewal or sustainment requirements over the next ten years.

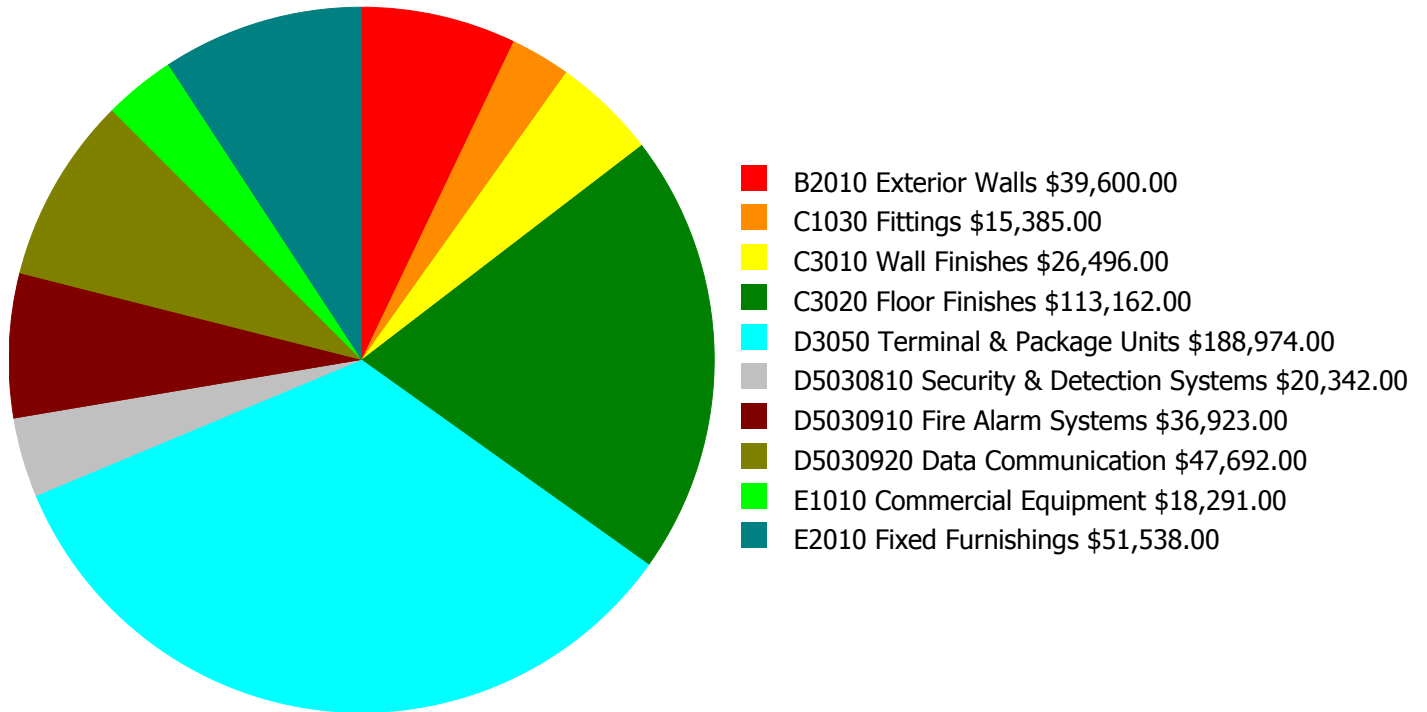
## Deficiency Summary by System

Current deficiencies included assemblies that have reached or exceeded their design life or components of the assemblies that are in need of repair. Assemblies that have reached their design life are identified as current deficiencies and assigned the distress 'Beyond Useful Life'. The following chart lists all current deficiencies associated with this facility.

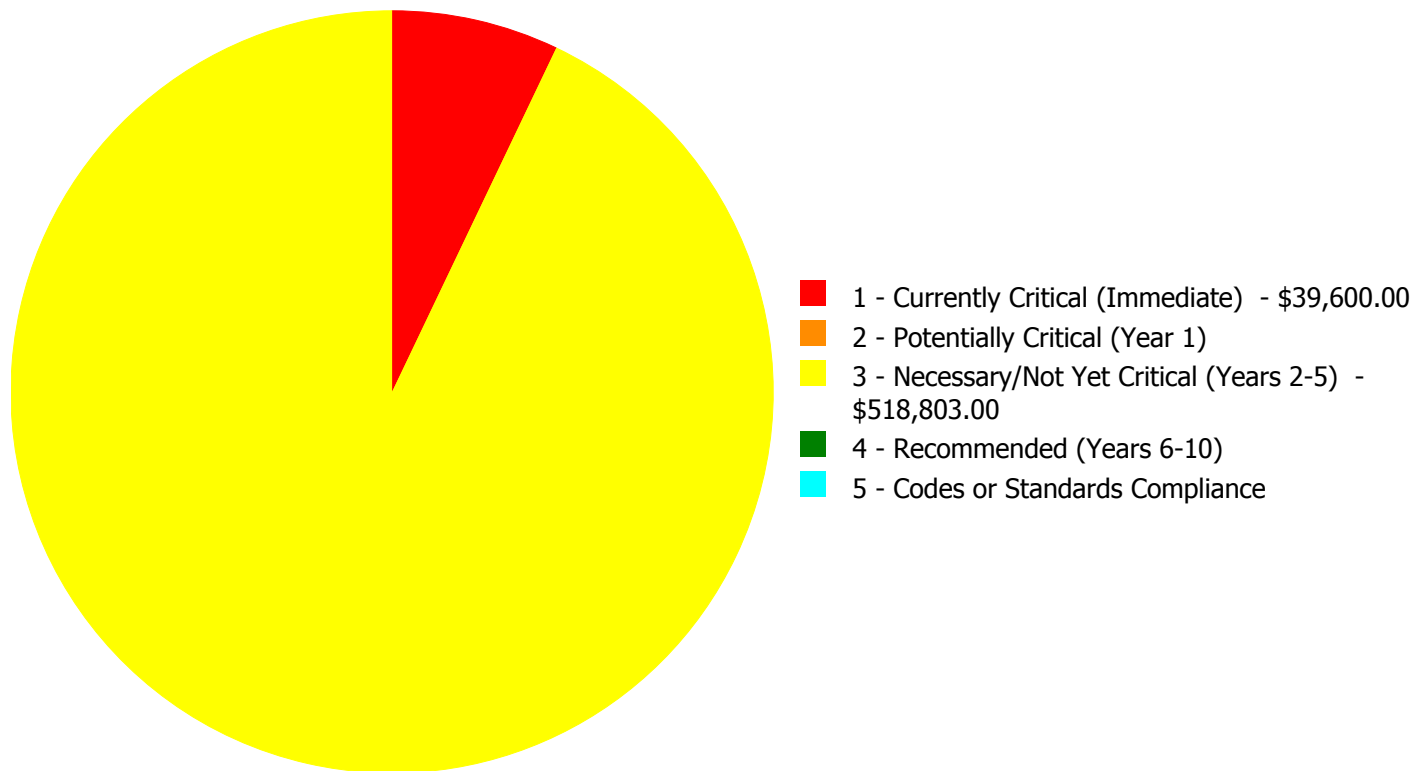
### Deficiency Summary by Priority

The following chart shows the total repair costs broken down by priority. Assessors assigned deficiencies within eCOMET to one of the following priority categories:

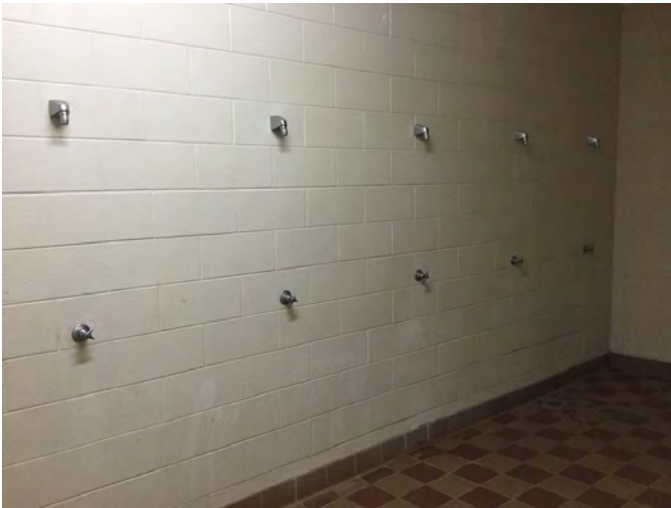
**System: C3010 - Wall Finishes**

**Location:** Throughout the Building  
**Distress:** Beyond Service Life  
**Category:** Deferred Maintenance  
**Priority:** 3 - Necessary/Not Yet Critical (Years 2-5)  
**Correction:** Renew System  
**Qty:** 7,770.00  
**Unit of Measure:** S.F.  
**Estimate:** \$26,496.00  
**Assessor Name:** Eduardo Lopez  
**Date Created:** 01/04/2017

**Notes:** The wall finishes are aged, scuffed, fading, stained and should be replaced.

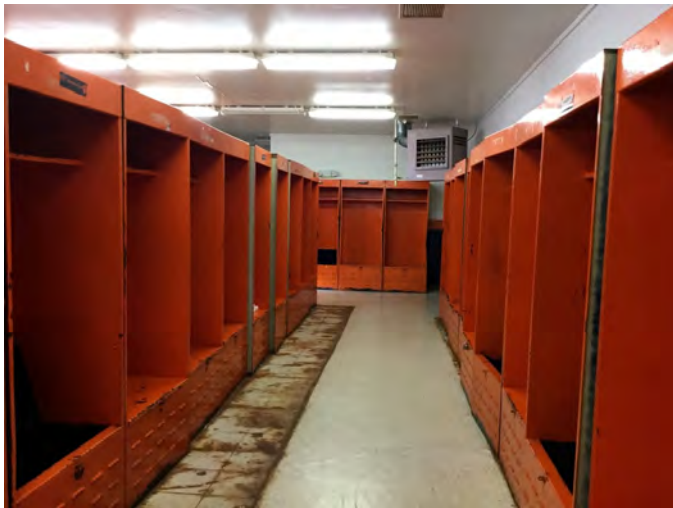
**System: E2010 - Fixed Furnishings**

**Location:** Throughout the Building  
**Distress:** Beyond Service Life  
**Category:** Deferred Maintenance  
**Priority:** 3 - Necessary/Not Yet Critical (Years 2-5)  
**Correction:** Renew System  
**Qty:** 7,770.00  
**Unit of Measure:** S.F.  
**Estimate:** \$51,538.00  
**Assessor Name:** Eduardo Lopez  
**Date Created:** 01/04/2017

**Notes:** The fixed furnishings are aged, in marginal condition, and should be replaced.

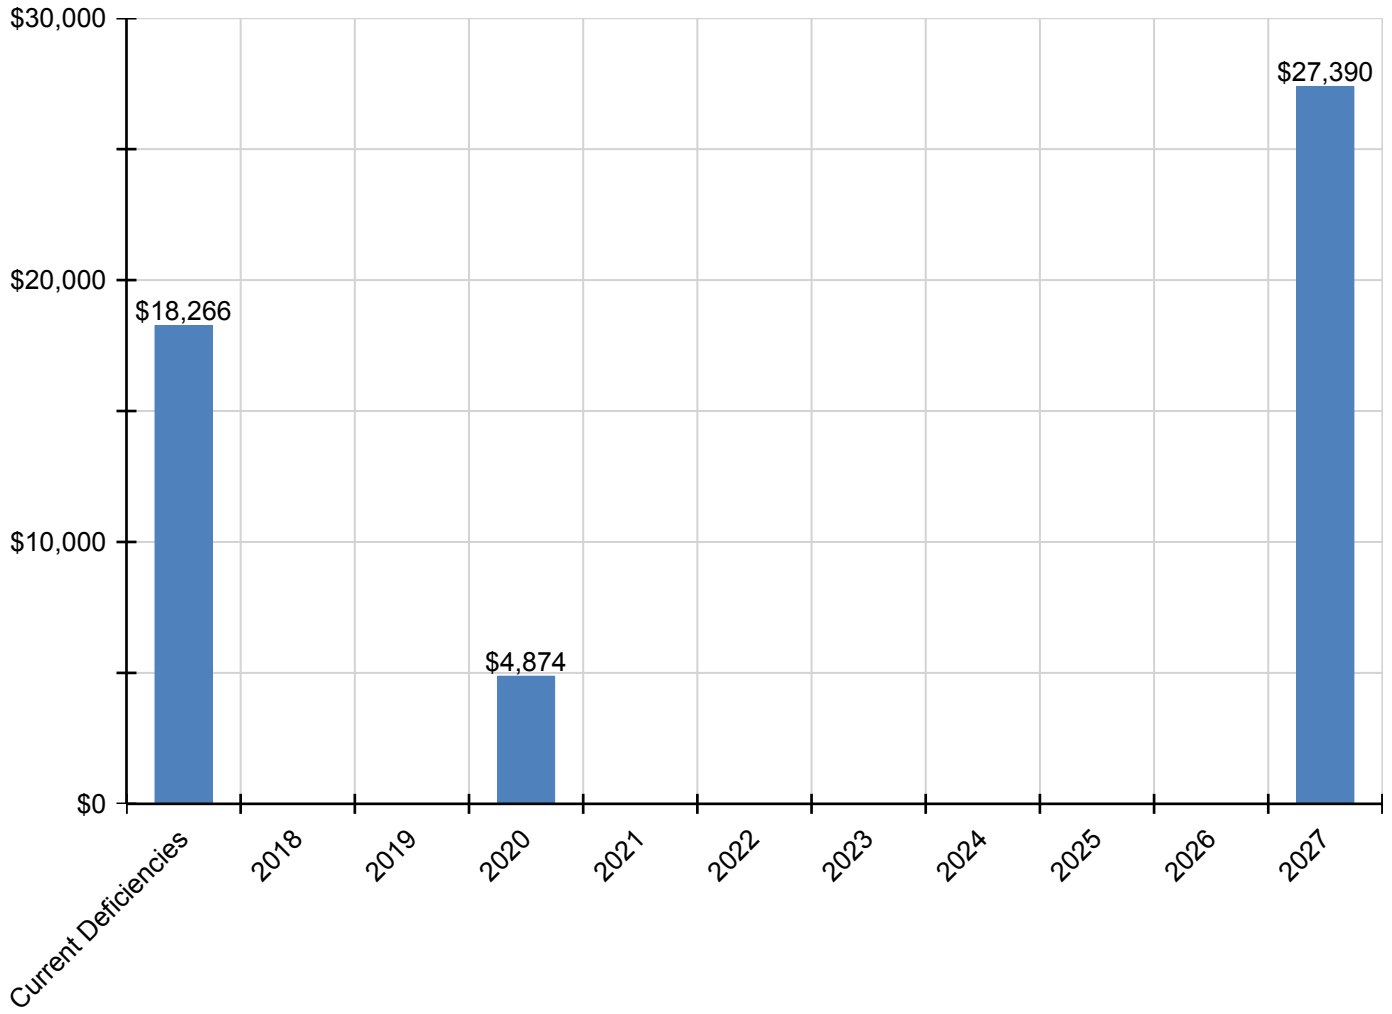
## Forecasted Capital Renewal Requirement

The following chart shows the current building deficiencies and forecasting capital renewal or sustainment requirements over the next ten years.

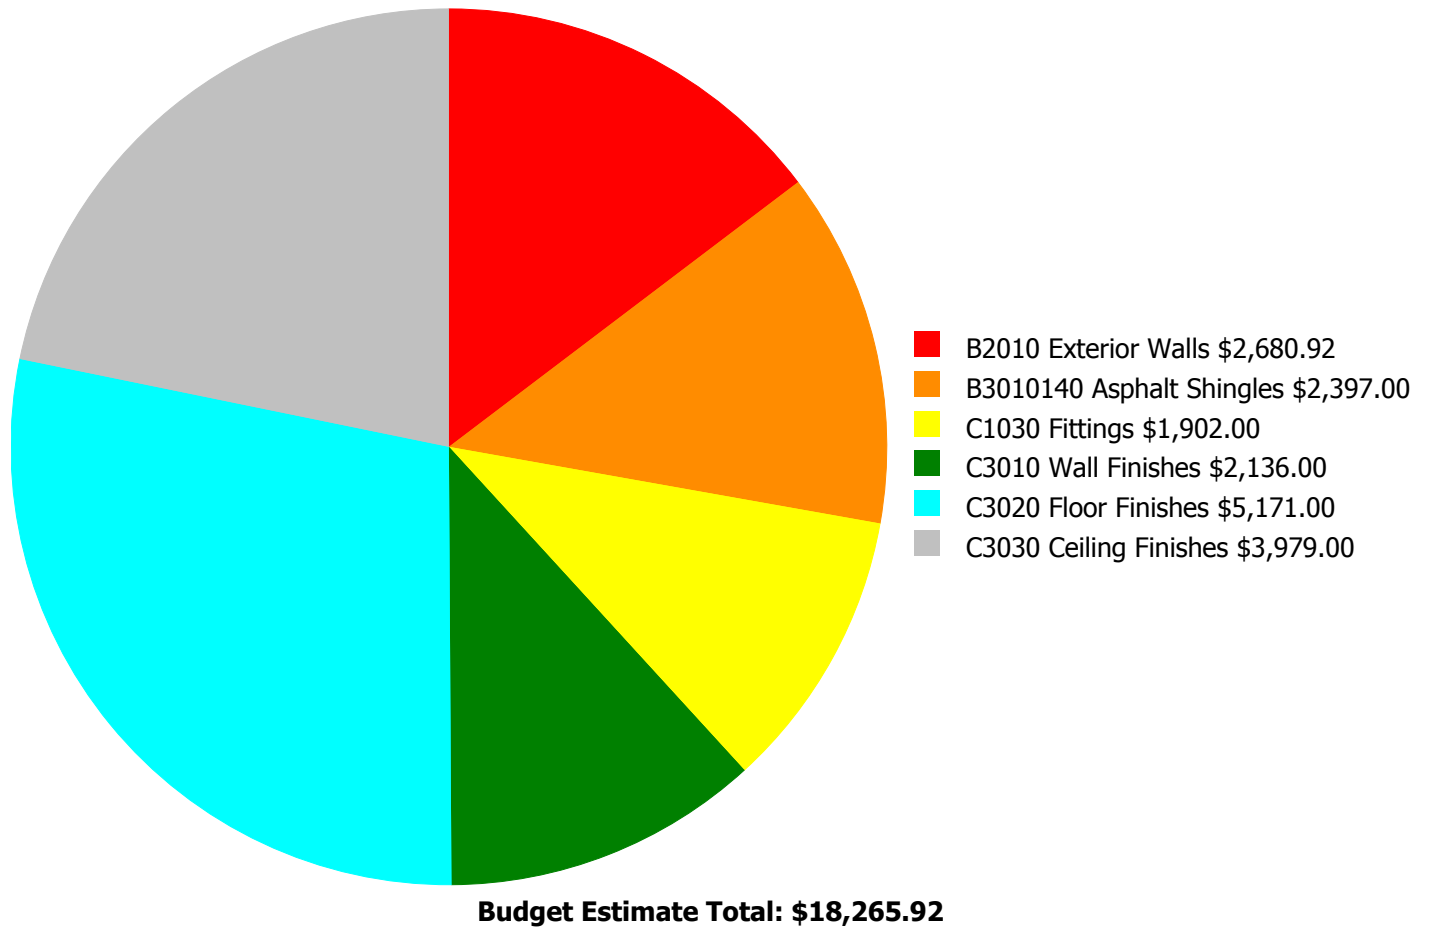
## Deficiency Summary by System

Current deficiencies included assemblies that have reached or exceeded their design life or components of the assemblies that are in need of repair. Assemblies that have reached their design life are identified as current deficiencies and assigned the distress 'Beyond Useful Life'. The following chart lists all current deficiencies associated with this facility.

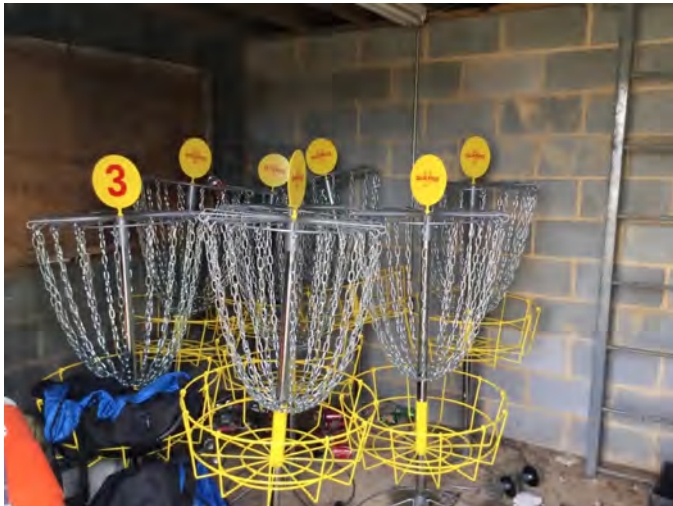
**System: C3010 - Wall Finishes**

**Location:** Throughout the Building  
**Distress:** Beyond Service Life  
**Category:** Deferred Maintenance  
**Priority:** 3 - Necessary/Not Yet Critical (Years 2-5)  
**Correction:** Renew System  
**Qty:** 380.00  
**Unit of Measure:** S.F.  
**Estimate:** \$2,136.00  
**Assessor Name:** Eduardo Lopez  
**Date Created:** 02/15/2017

**Notes:** The wall finishes are aged, scuffed, fading, stained and should be replaced.

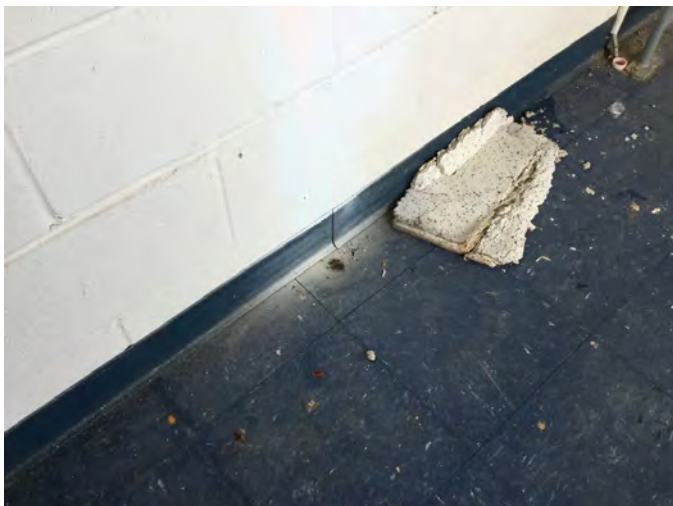
**System: C3020 - Floor Finishes**

**Location:** Throughout the Building  
**Distress:** Beyond Service Life  
**Category:** Deferred Maintenance  
**Priority:** 3 - Necessary/Not Yet Critical (Years 2-5)  
**Correction:** Renew System  
**Qty:** 380.00  
**Unit of Measure:** S.F.  
**Estimate:** \$5,171.00  
**Assessor Name:** Eduardo Lopez  
**Date Created:** 02/15/2017

**Notes:** The original flooring is in poor conditions and should be replaced.

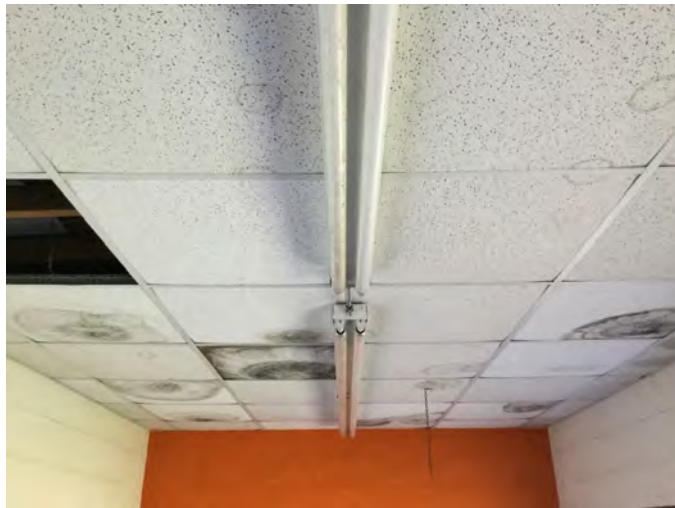
**System: C3030 - Ceiling Finishes**

**Location:** Throughout the Building  
**Distress:** Beyond Service Life  
**Category:** Deferred Maintenance  
**Priority:** 3 - Necessary/Not Yet Critical (Years 2-5)  
**Correction:** Renew System  
**Qty:** 380.00  
**Unit of Measure:** S.F.  
**Estimate:** \$3,979.00  
**Assessor Name:** Eduardo Lopez  
**Date Created:** 02/15/2017

**Notes:** The original ceiling finishes are aged, failing and should be replaced.

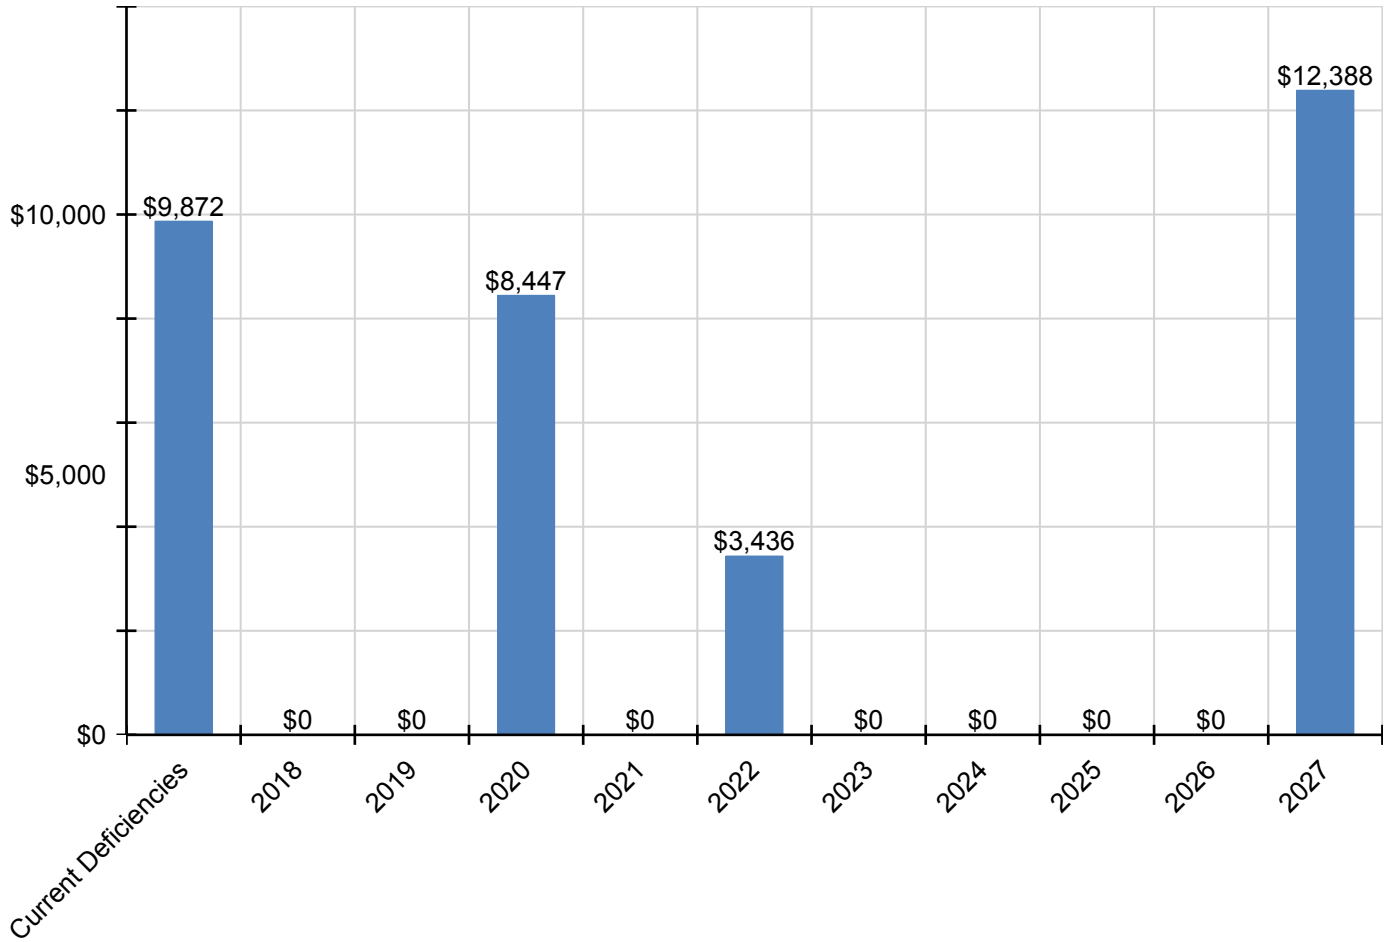
## Forecasted Capital Renewal Requirement

The following chart shows the current building deficiencies and forecasting capital renewal or sustainment requirements over the next ten years.

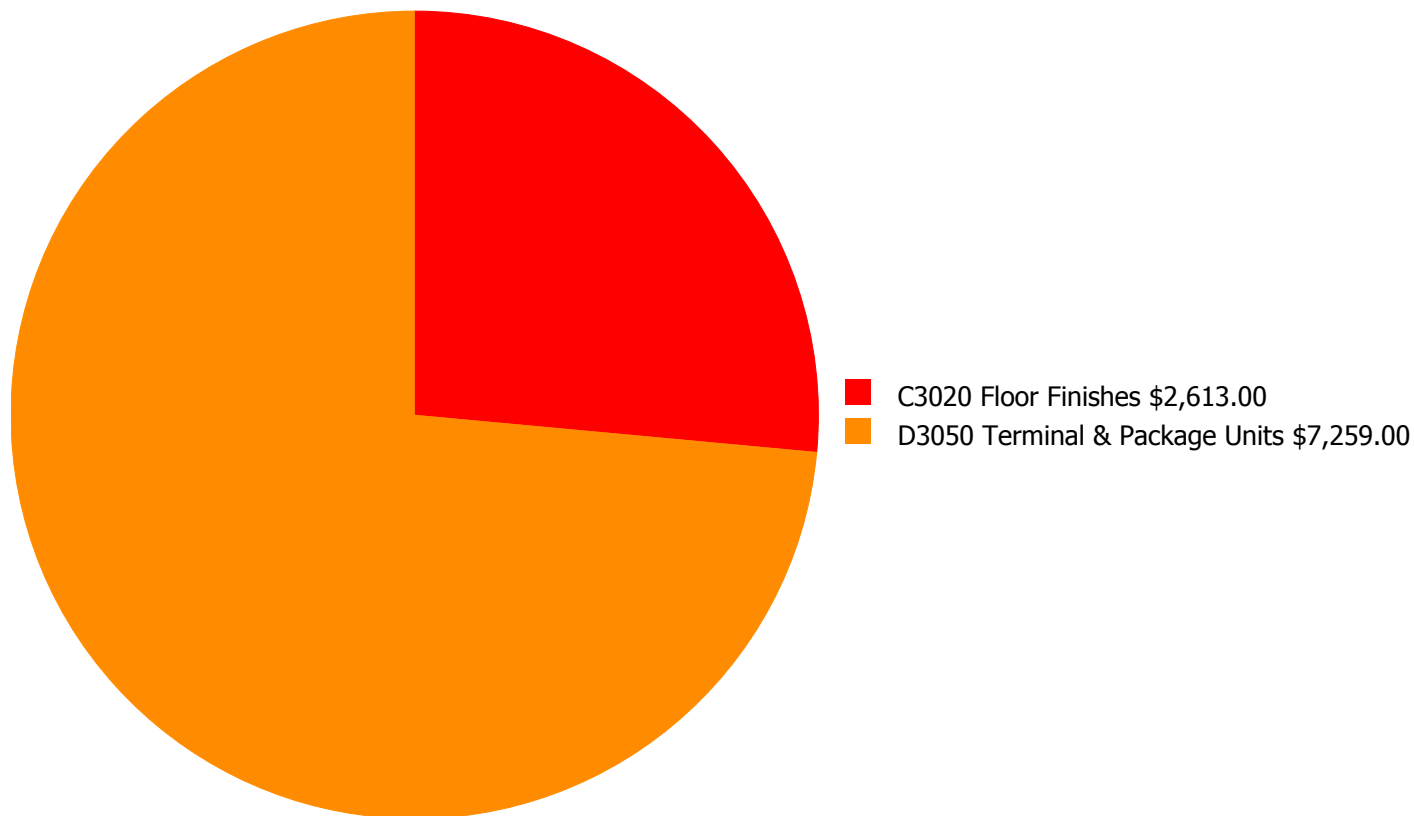
### Deficiency Summary by System

Current deficiencies included assemblies that have reached or exceeded their design life or components of the assemblies that are in need of repair. Assemblies that have reached their design life are identified as current deficiencies and assigned the distress 'Beyond Useful Life'. The following chart lists all current deficiencies associated with this facility.

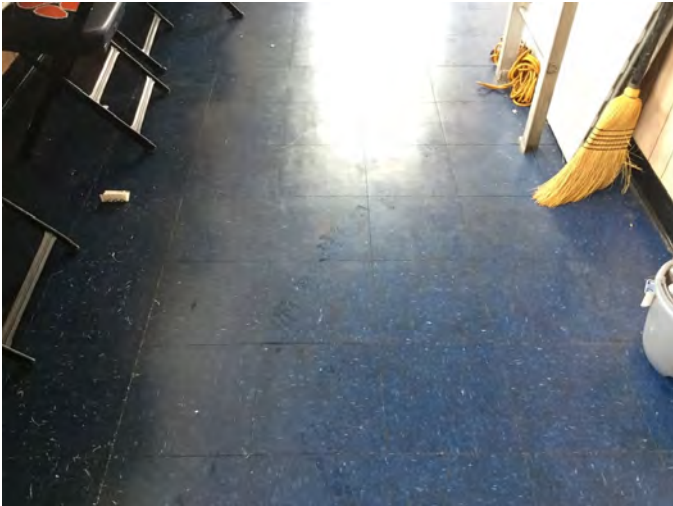
#### System: C3020 - Floor Finishes

**Location:** Throughout the Building  
**Distress:** Beyond Service Life  
**Category:** Deferred Maintenance  
**Priority:** 3 - Necessary/Not Yet Critical (Years 2-5)  
**Correction:** Renew System  
**Qty:** 192.00  
**Unit of Measure:** S.F.  
**Estimate:** \$2,613.00  
**Assessor Name:** Eduardo Lopez  
**Date Created:** 01/04/2017

**Notes:** The original flooring is in poor conditions and should be replaced.

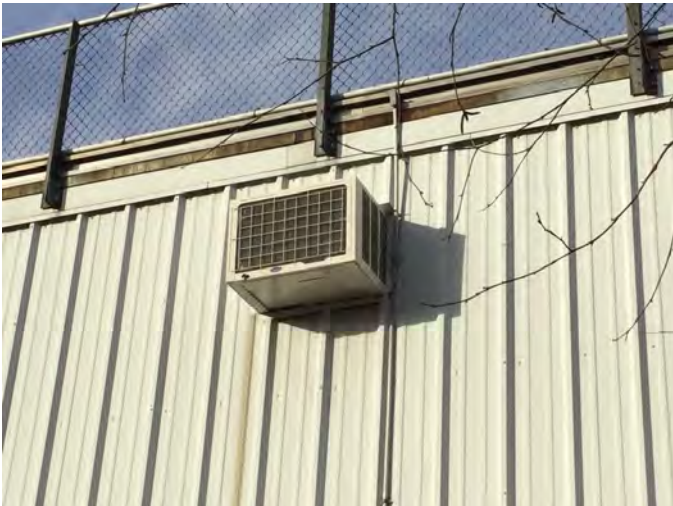
#### System: D3050 - Terminal & Package Units

**Location:** Throughout the Building  
**Distress:** Beyond Service Life  
**Category:** Deferred Maintenance  
**Priority:** 3 - Necessary/Not Yet Critical (Years 2-5)  
**Correction:** Renew System  
**Qty:** 192.00  
**Unit of Measure:** S.F.  
**Estimate:** \$7,259.00  
**Assessor Name:** Eduardo Lopez  
**Date Created:** 01/04/2017

**Notes:** Terminal and package units are beyond their expected service life and should be scheduled for replacement.

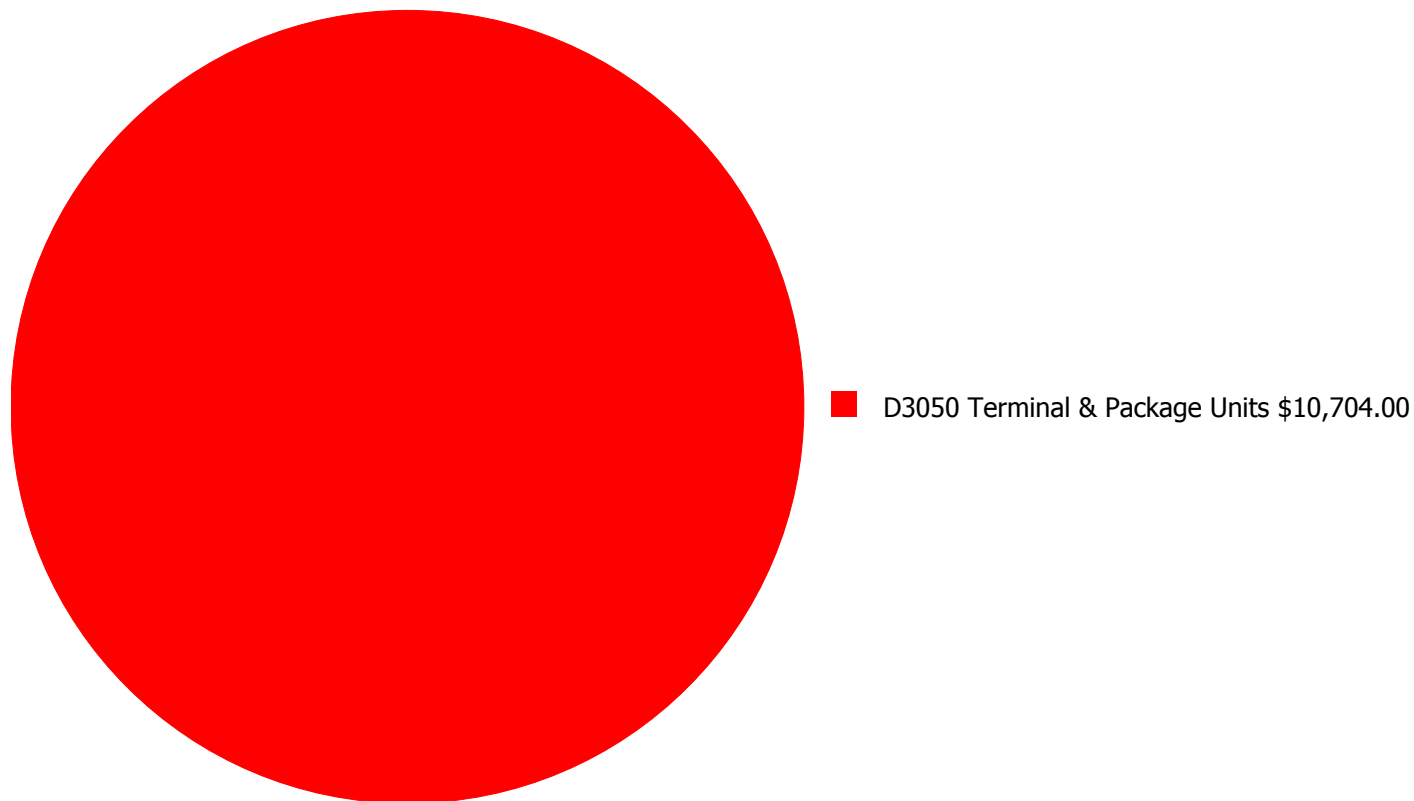
## Deficiency Summary by System

Current deficiencies included assemblies that have reached or exceeded their design life or components of the assemblies that are in need of repair. Assemblies that have reached their design life are identified as current deficiencies and assigned the distress 'Beyond Useful Life'. The following chart lists all current deficiencies associated with this facility.

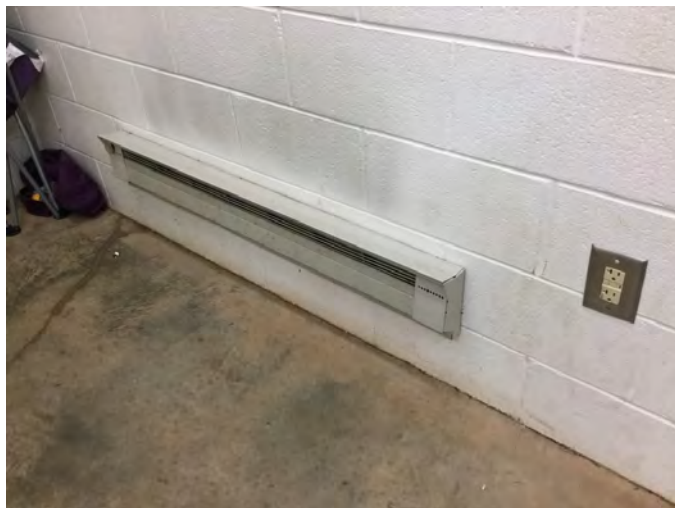
#### System: D3050 - Terminal & Package Units

**Location:** Throughout the Building  
**Distress:** Beyond Service Life  
**Category:** Deferred Maintenance  
**Priority:** 3 - Necessary/Not Yet Critical (Years 2-5)  
**Correction:** Renew System  
**Qty:** 912.00  
**Unit of Measure:** S.F.  
**Estimate:** \$10,704.00  
**Assessor Name:** Eduardo Lopez  
**Date Created:** 01/04/2017

**Notes:** Terminal and package units are beyond their expected service life and should be scheduled for replacement.

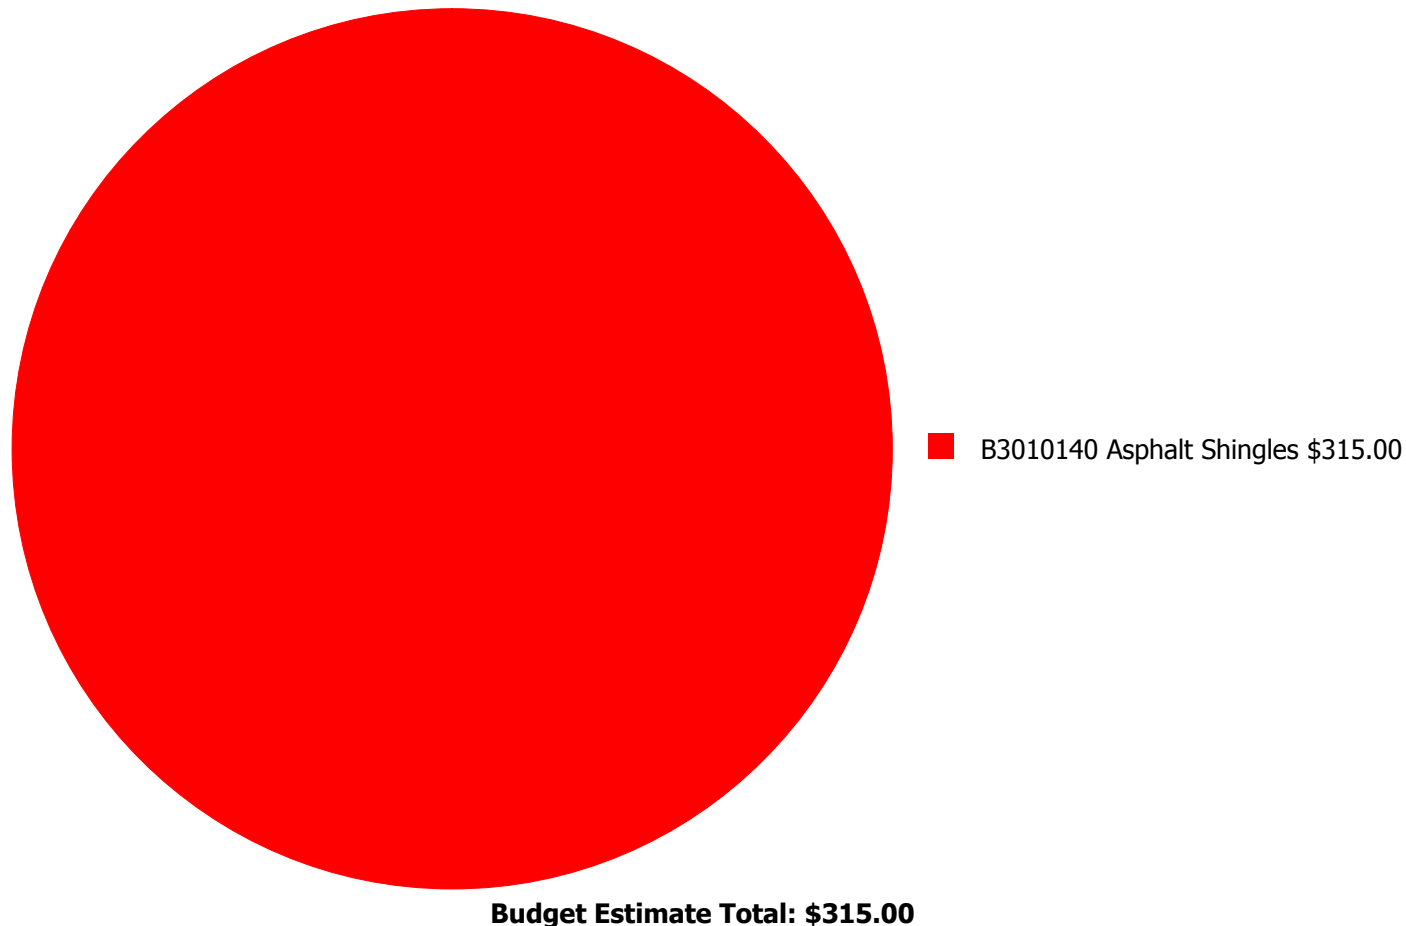
## Deficiency Summary by System

Current deficiencies included assemblies that have reached or exceeded their design life or components of the assemblies that are in need of repair. Assemblies that have reached their design life are identified as current deficiencies and assigned the distress 'Beyond Useful Life'. The following chart lists all current deficiencies associated with this facility.

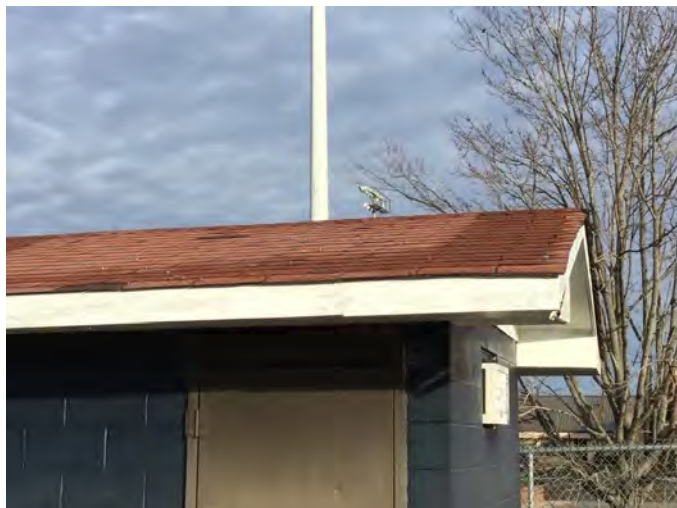
#### **System: B3010140 - Asphalt Shingles**

**Location:** Roof  
**Distress:** Beyond Service Life  
**Category:** Deferred Maintenance  
**Priority:** 3 - Necessary/Not Yet Critical (Years 2-5)  
**Correction:** Renew System  
**Qty:** 50.00  
**Unit of Measure:** S.F.  
**Estimate:** \$315.00  
**Assessor Name:** Terence Davis  
**Date Created:** 01/04/2017

**Notes:** The asphalt shingles are aged and should be scheduled for replacement.

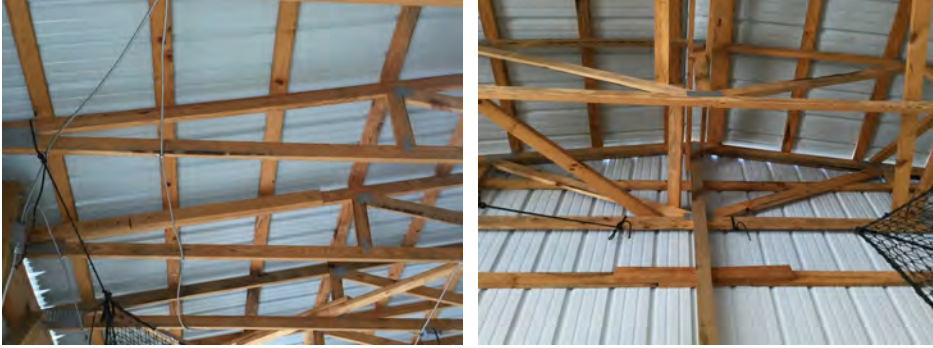
**System:** B1020 - Roof Construction

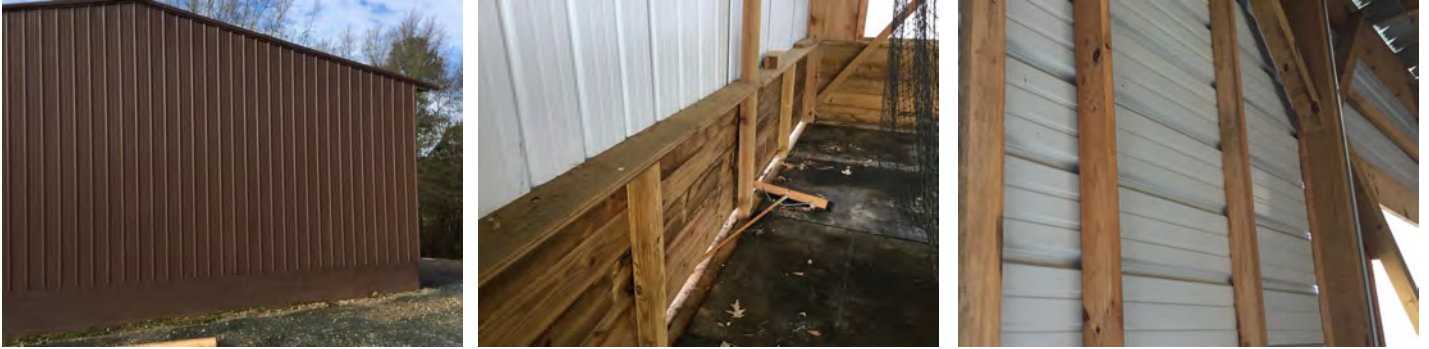
**System:** B2010 - Exterior Walls

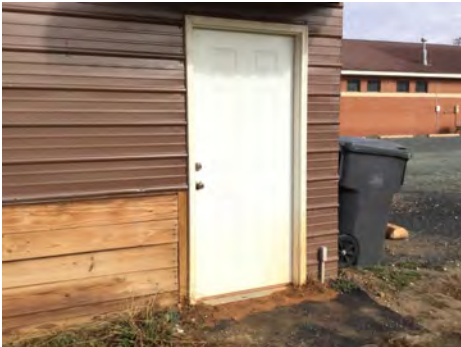
**System:** B2030 - Exterior Doors

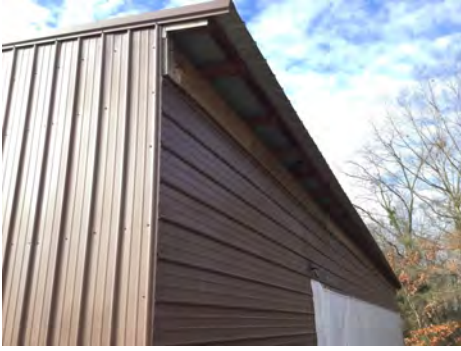
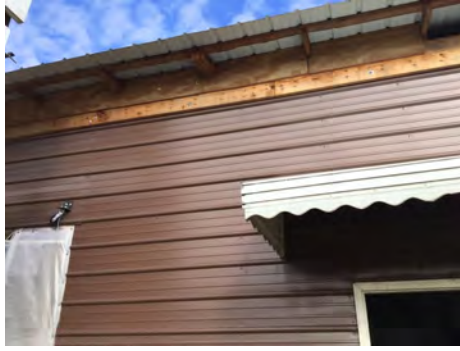
**System:** B3010130 - Preformed Metal Roofing

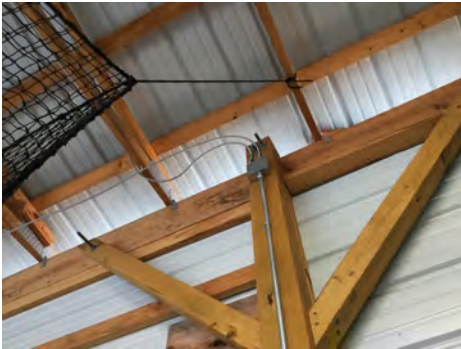
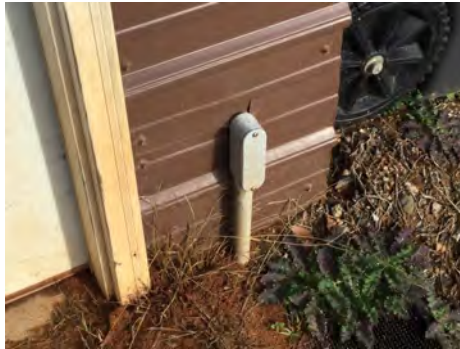
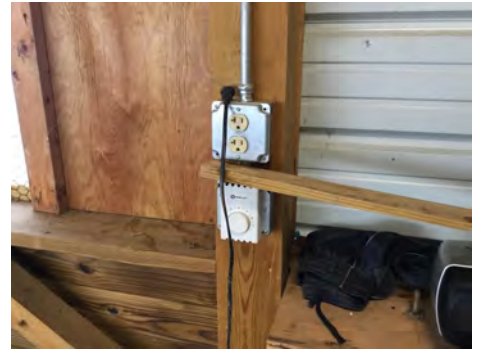
**System:** D5020 - Branch Wiring

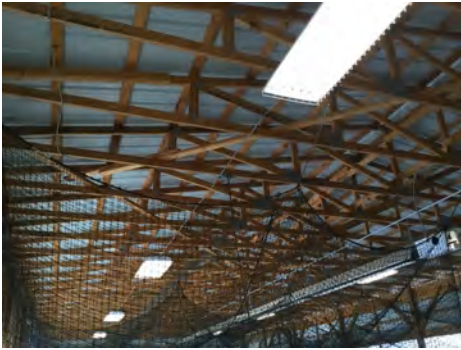
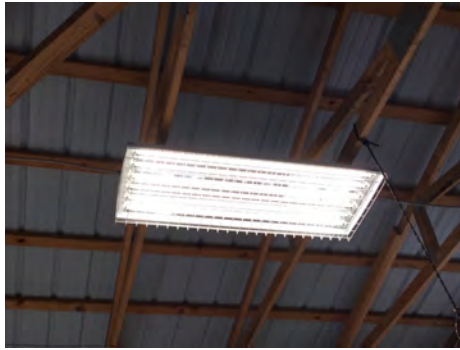
**System:** D5020 - Lighting
