# Anson Middle

## Campus Assessment Report

March 7, 2017

## Campus Assessment Report - 1966 Building, Cafe/Gym

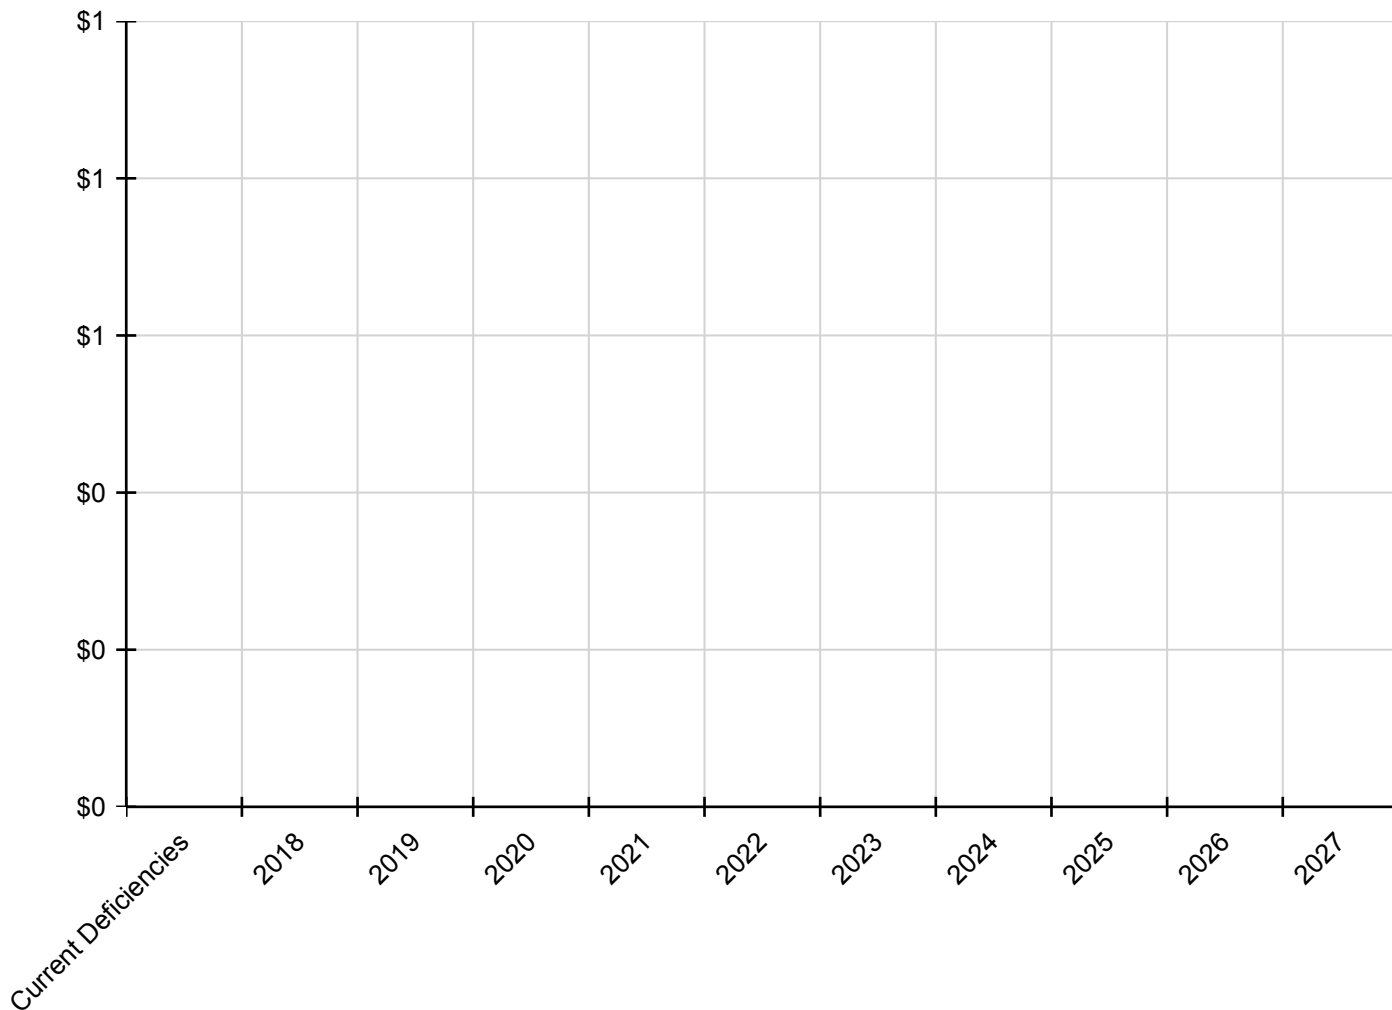
The following chart shows the current building deficiencies and forecasting capital renewal or sustainment requirements over the next ten years.

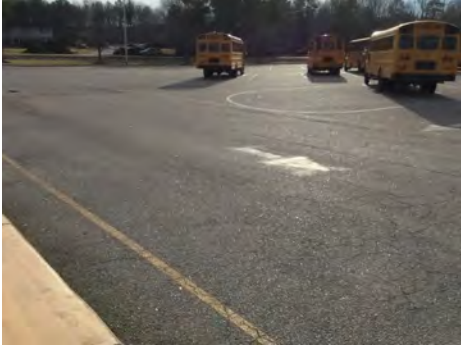
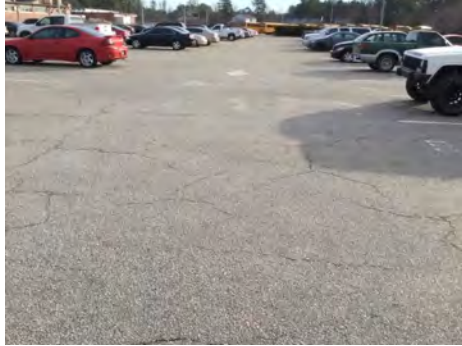
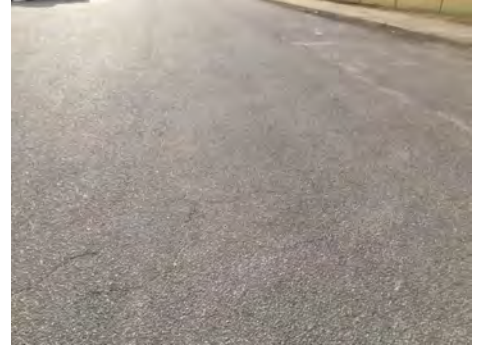
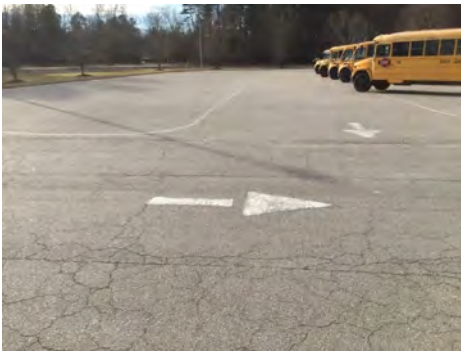
**System:** G2010 - Roadways

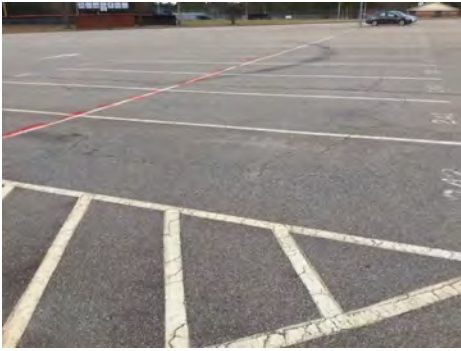
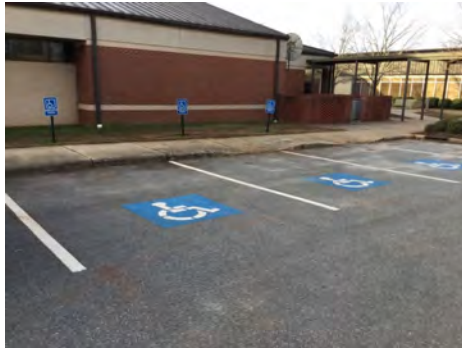
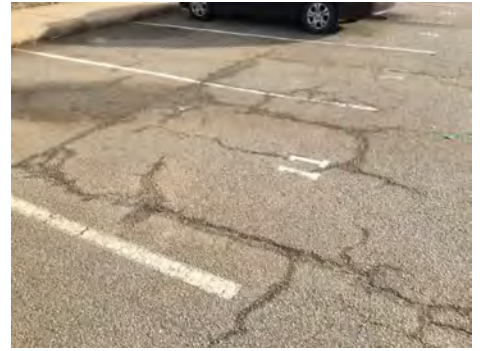
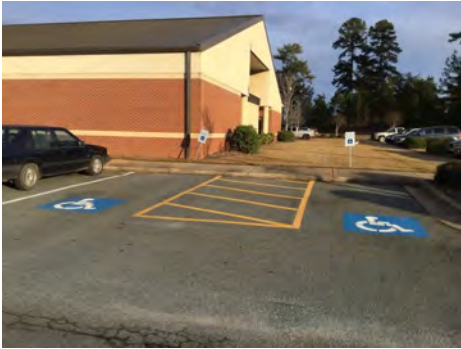
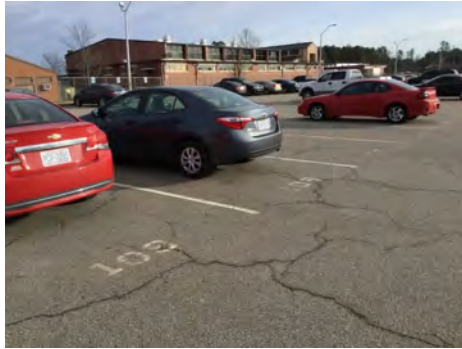
**System:** G2020 - Parking Lots

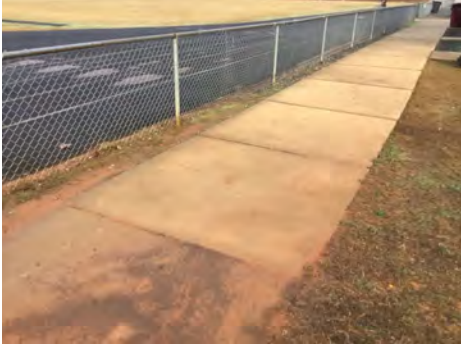
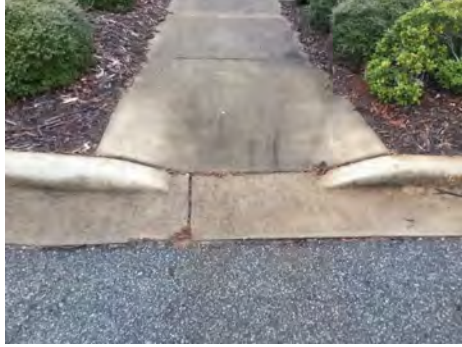
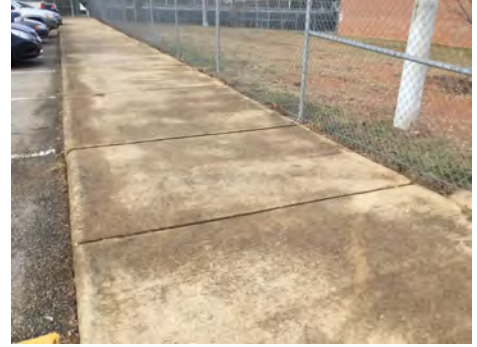
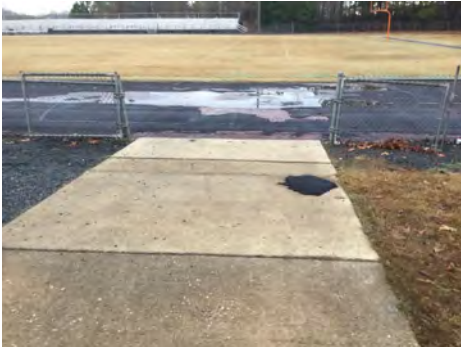
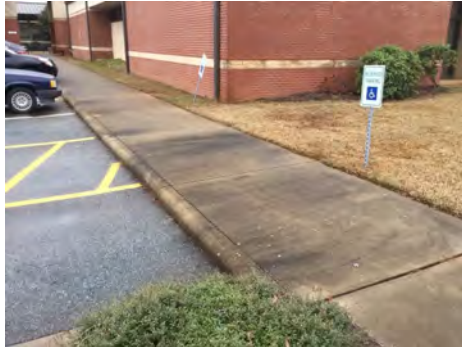
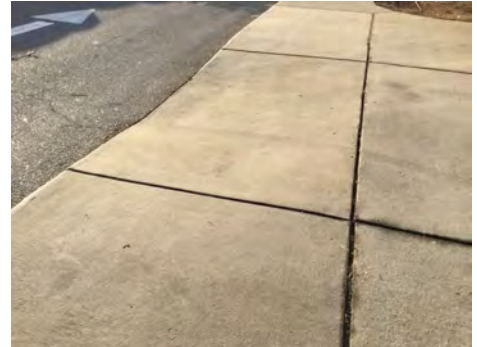
**System:** G2030 - Pedestrian Paving

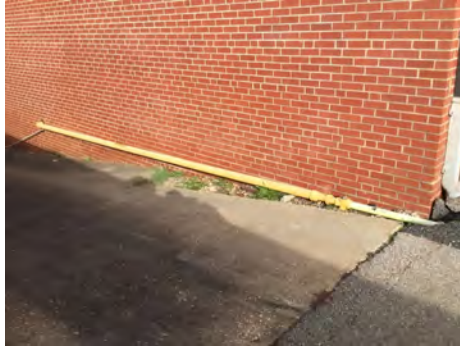
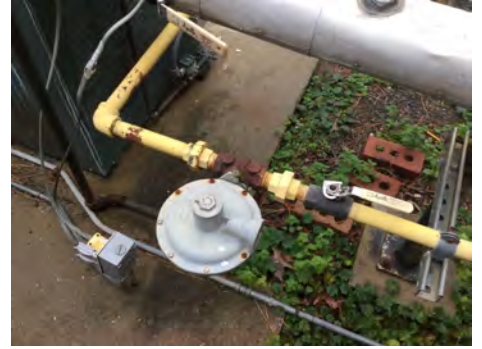
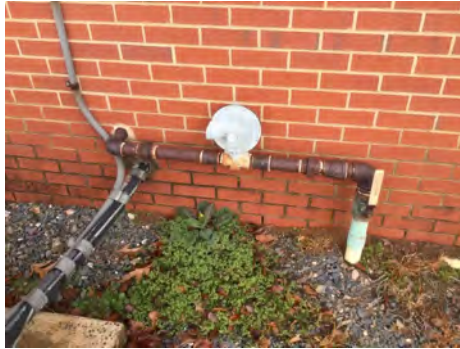
**System:** G3060 - Fuel Distribution

**Note:** Supplies Building E, H, K and W

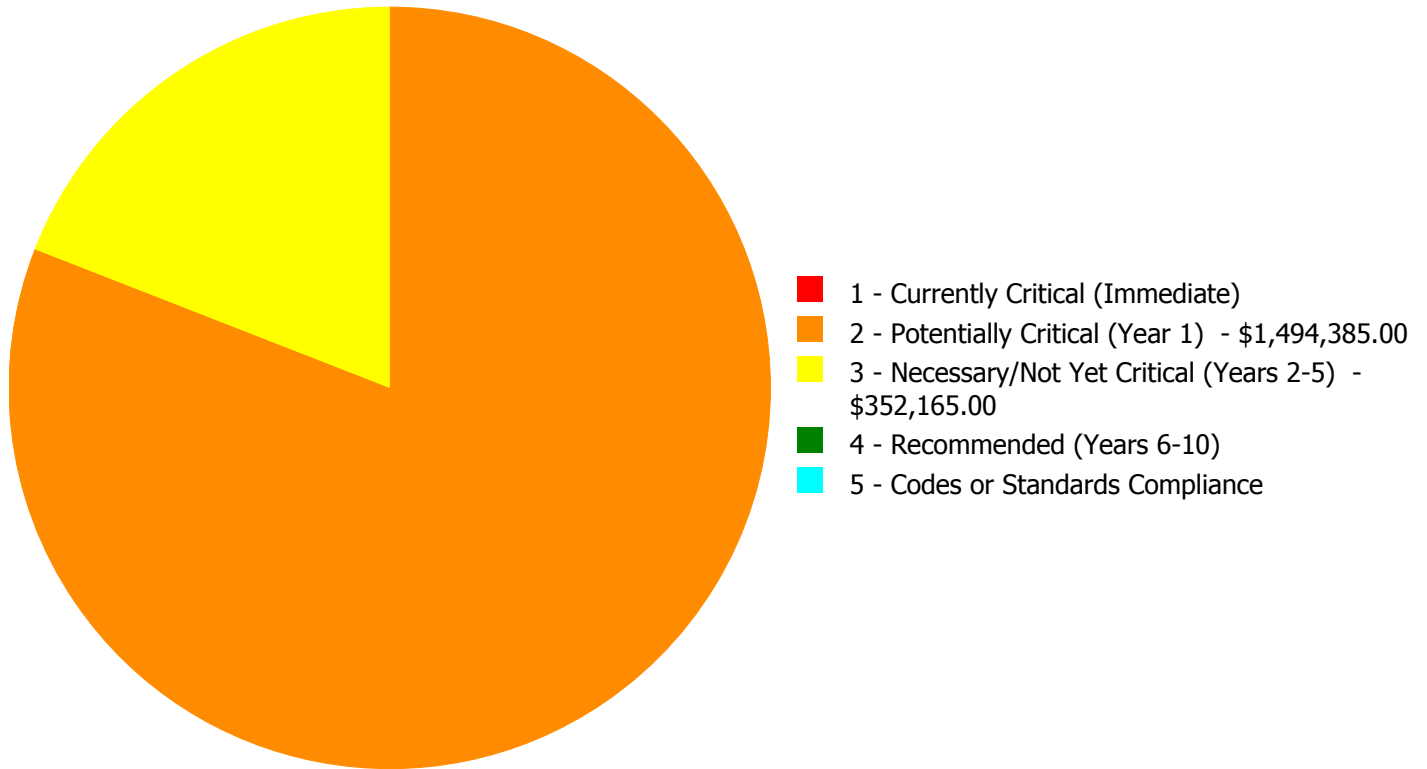
## Deficiency Summary by Priority

The following chart shows the total repair costs broken down by priority. Assessors assigned deficiencies within eCOMET to one of the following priority categories:

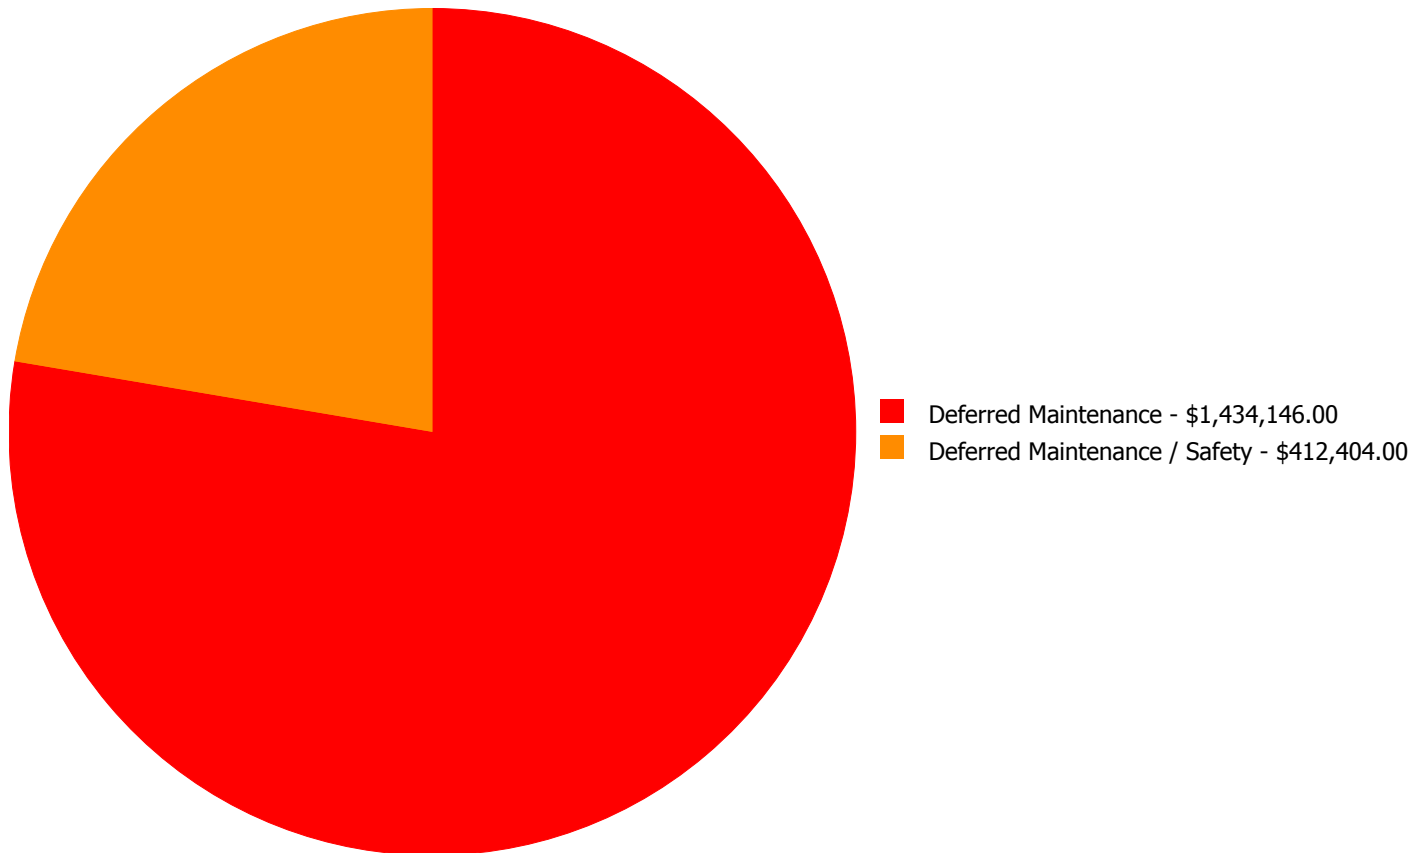
## Deficiency Summary by Category

The following chart shows the total repair costs broken down by deficiency categories. Assessors assigned deficiencies to one of the following categories:

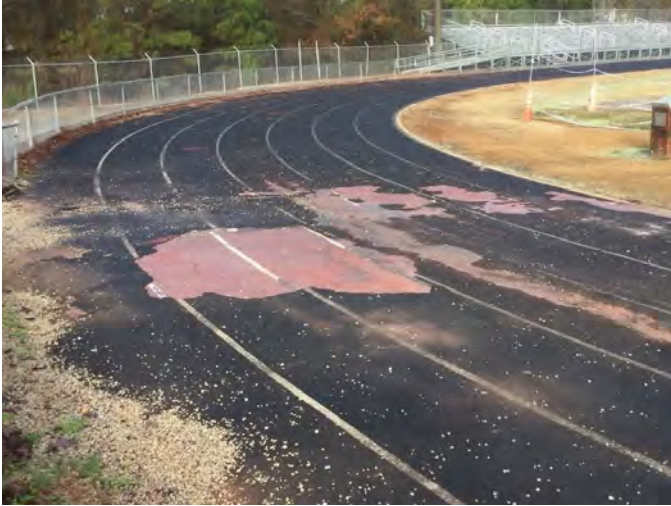
#### System: G2040950 - Track

**Location:** Site  
**Distress:** Beyond Service Life  
**Category:** Deferred Maintenance / Safety  
**Priority:** 2 - Potentially Critical (Year 1)  
**Correction:** Renew System  
**Qty:** 210,625.00  
**Unit of Measure:** S.F.  
**Estimate:** \$412,404.00  
**Assessor Name:** Eduardo Lopez  
**Date Created:** 01/04/2017

**Notes:** The track is in deteriorating condition with many trip hazards and should be replaced.

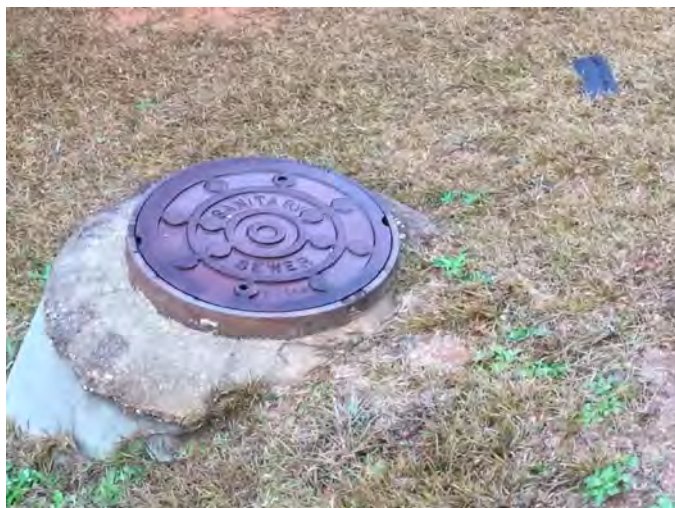
**System: G3020 - Sanitary Sewer**

**Location:** Site  
**Distress:** Beyond Service Life  
**Category:** Deferred Maintenance  
**Priority:** 3 - Necessary/Not Yet Critical (Years 2-5)  
**Correction:** Renew System  
**Qty:** 210,625.00  
**Unit of Measure:** S.F.  
**Estimate:** \$352,165.00  
**Assessor Name:** Eduardo Lopez  
**Date Created:** 02/17/2017

**Notes:** The sanitary sewer system is beyond its expected service life and should be scheduled for replacement.
