NC School District/080 Bertie County/Middle School

Bertie Middle

Campus Assessment Report

March 8, 2017

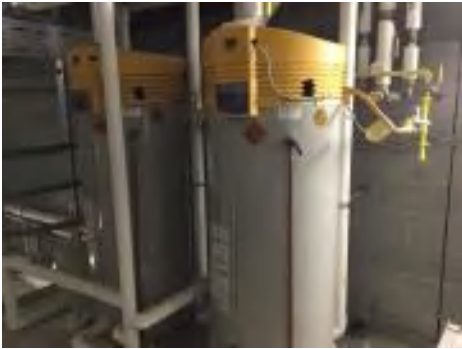
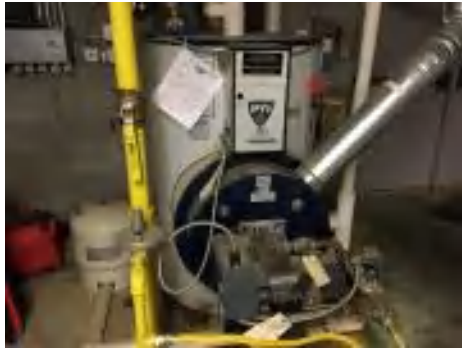
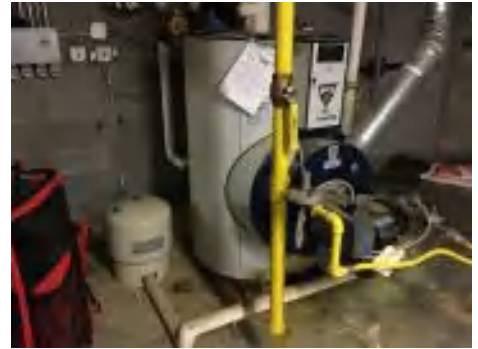
System: D2020 - Domestic Water Distribution

Note: 125 Gal gas water heater - Mech Room
100 Gal gas water heater - Mezzanine Gym (2)

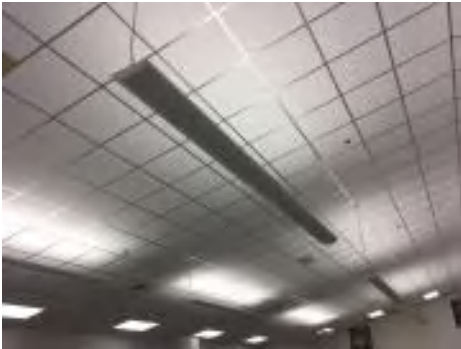
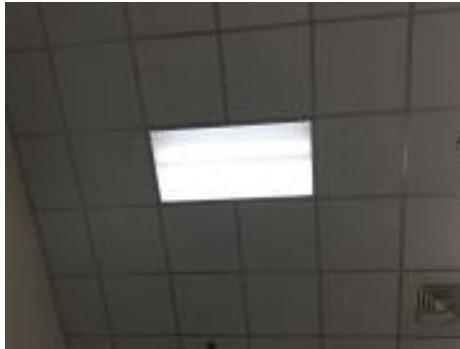
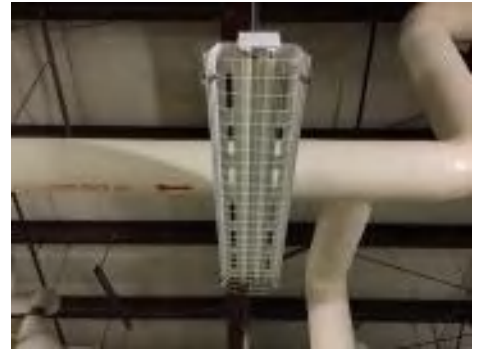
System: D5020 - Lighting

Note: T-8 lights

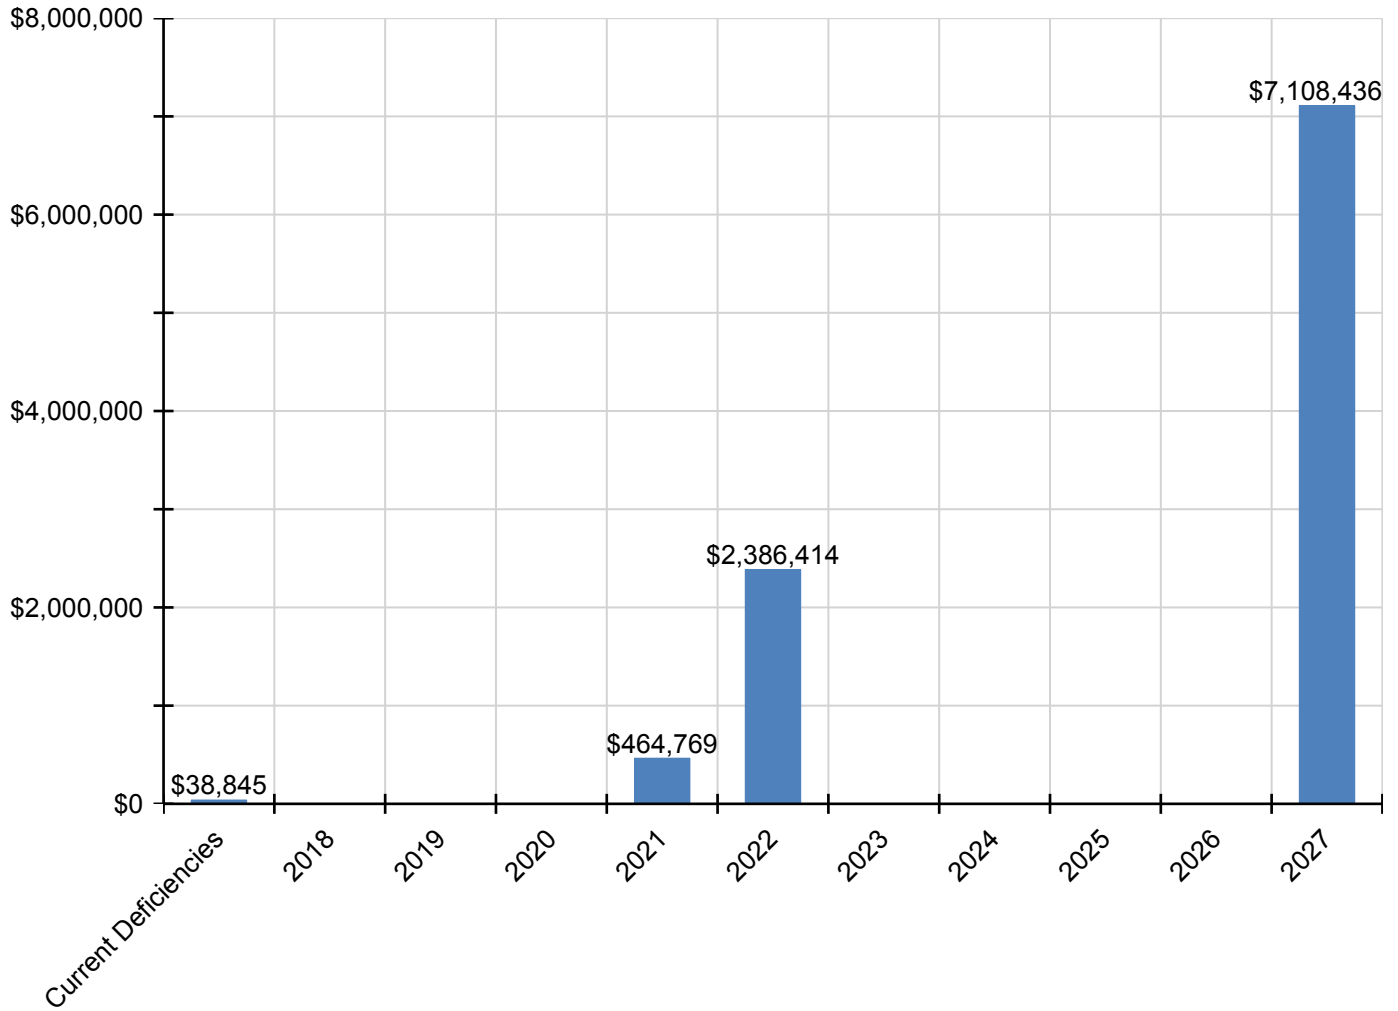
Forecasted Capital Renewal Requirement

The following chart shows the current building deficiencies and forecasting capital renewal or sustainment requirements over the next ten years.

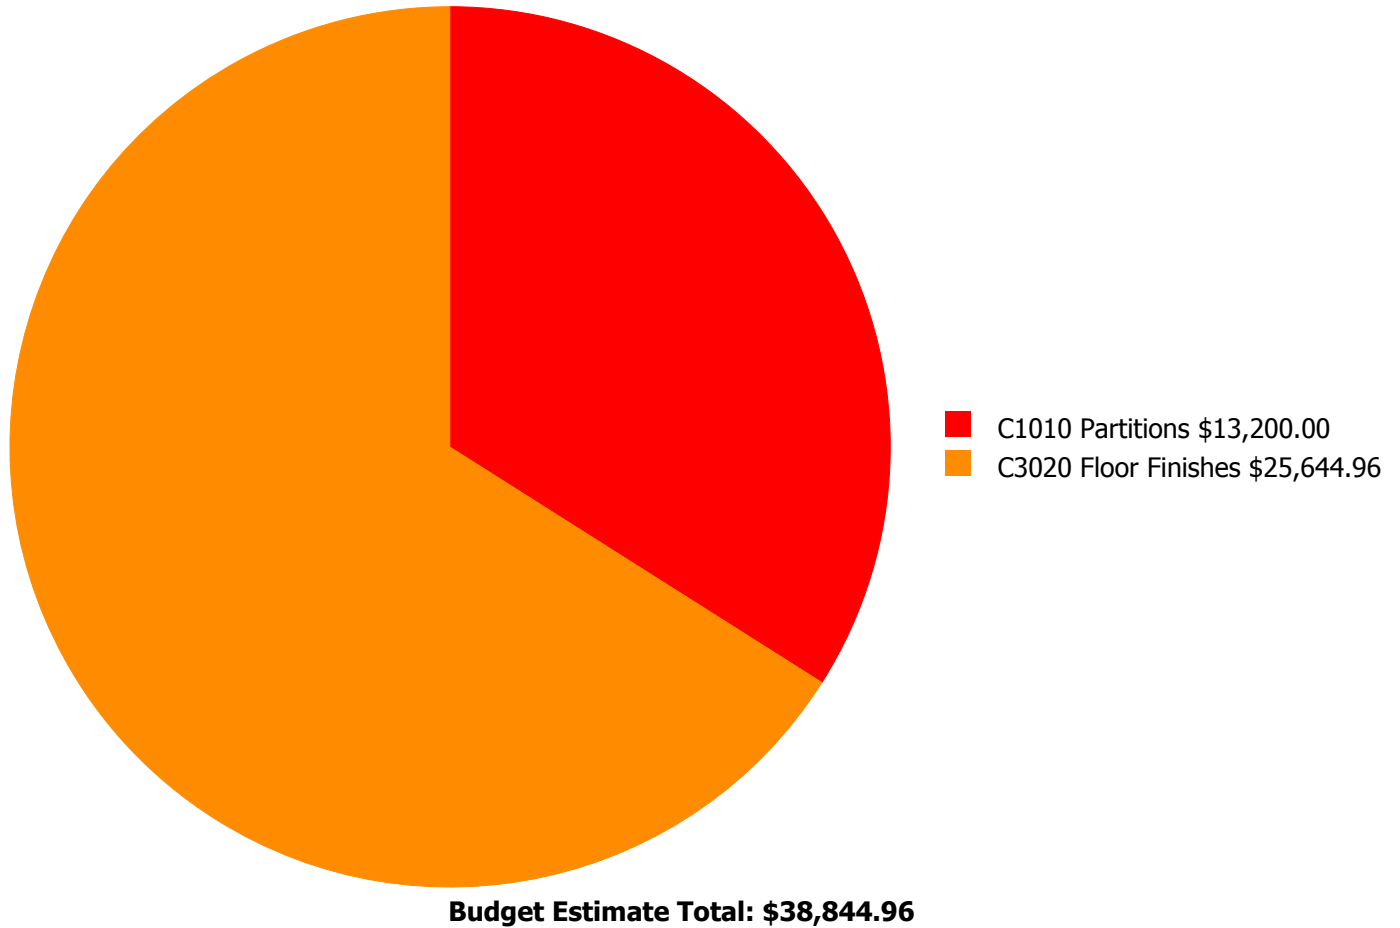
Deficiency Summary by System

Current deficiencies included assemblies that have reached or exceeded their design life or components of the assemblies that are in need of repair. Assemblies that have reached their design life are identified as current deficiencies and assigned the distress 'Beyond Useful Life'. The following chart lists all current deficiencies associated with this facility.

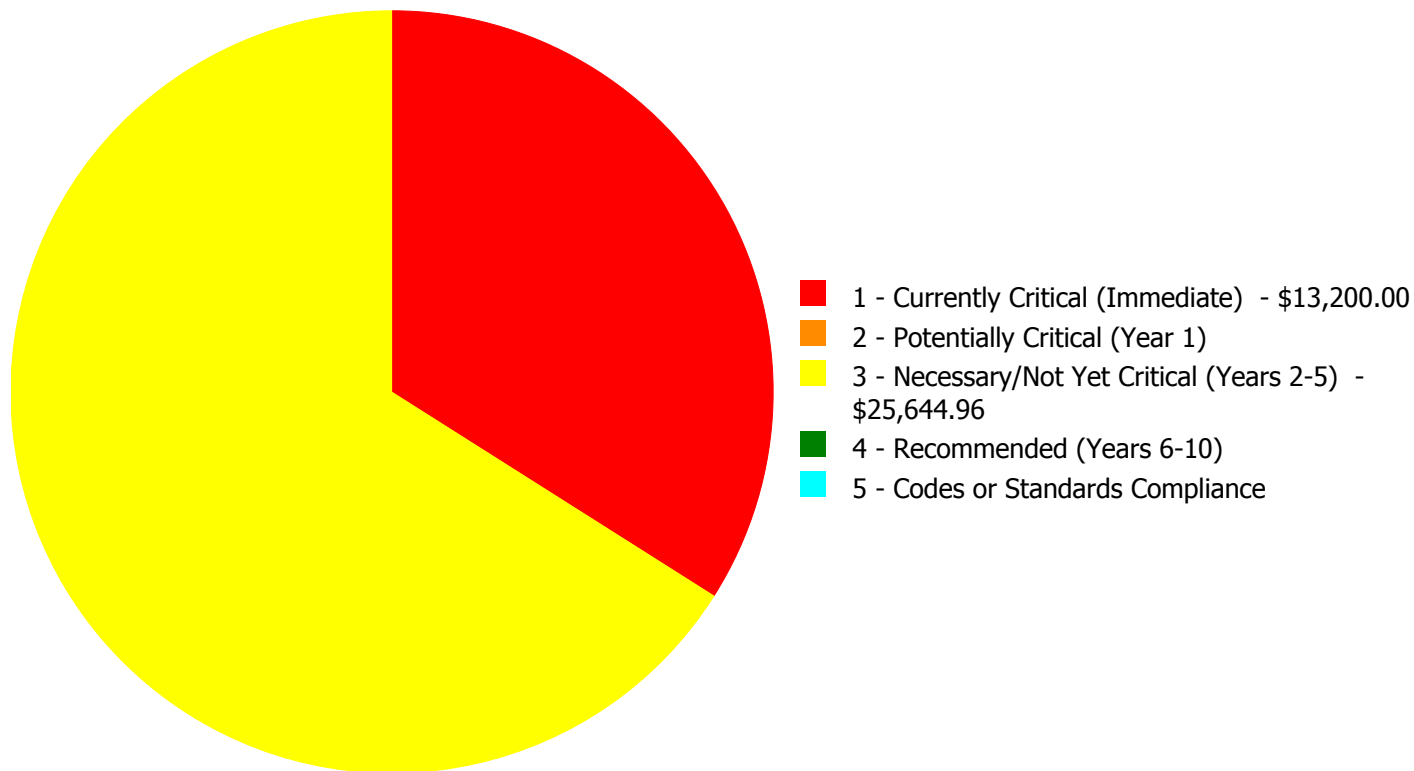
Deficiency Summary by Priority

The following chart shows the total repair costs broken down by priority. Assessors assigned deficiencies within eCOMET to one of the following priority categories:

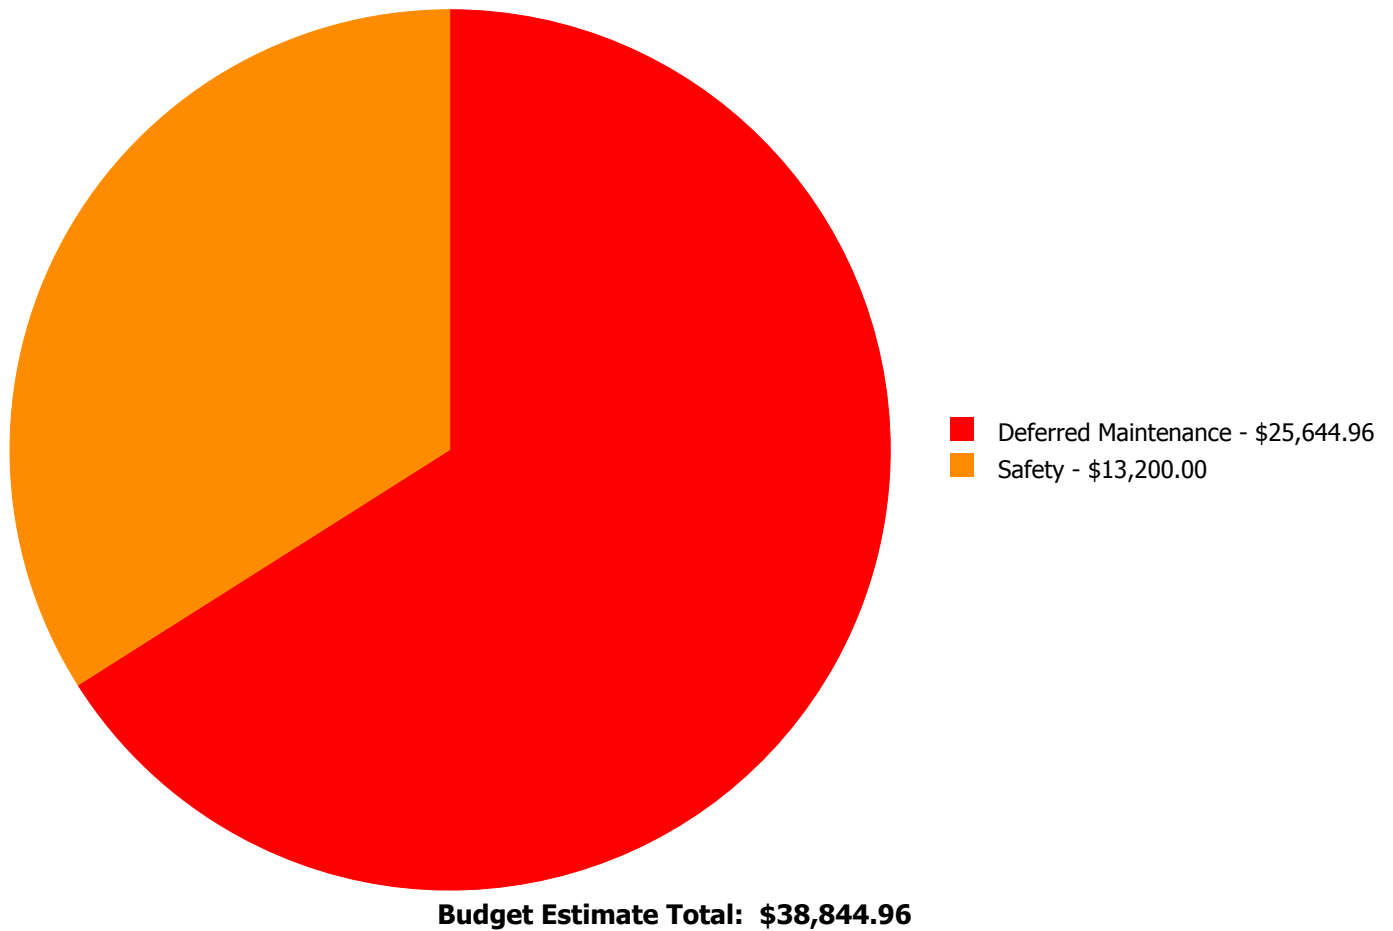
Deficiency Summary by Category

The following chart shows the total repair costs broken down by deficiency categories. Assessors assigned deficiencies to one of the following categories:

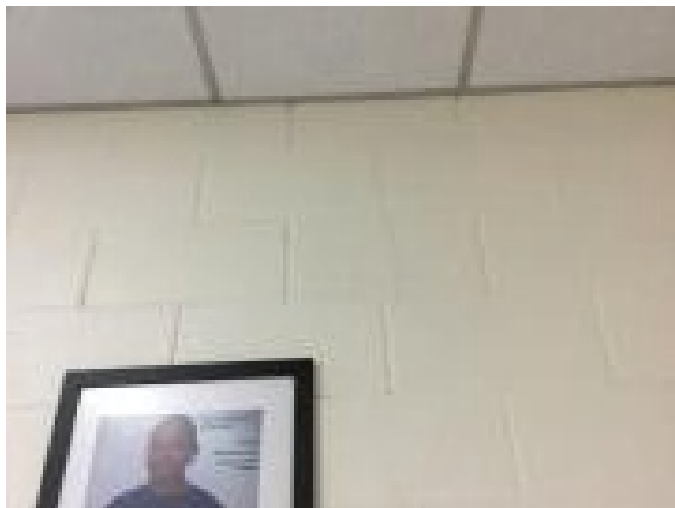
System: C1010 - Partitions

Location: Gymnasium and hallway
Distress: Failing
Category: Safety
Priority: 1 - Currently Critical (Immediate)
Correction: Engineering Study
Qty: 1.00
Unit of Measure: Ea.
Estimate: \$13,200.00
Assessor Name: Somnath Das
Date Created: 01/31/2017

Notes: The partition wall is showing visible cracks which should be studied by a professional engineer.

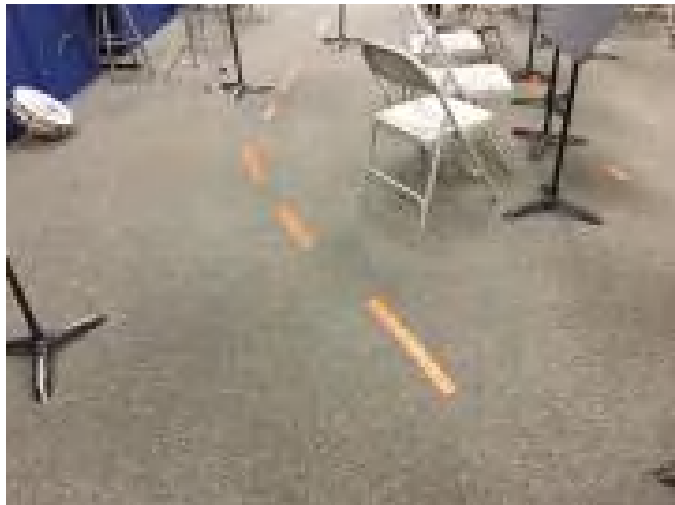
System: C3020 - Floor Finishes

Location: Media Center, Office Area, Band Room and Classroom

Distress: Beyond Service Life

Correction: Replace carpet

Notes: The carpet is beyond its service life and should be replaced.

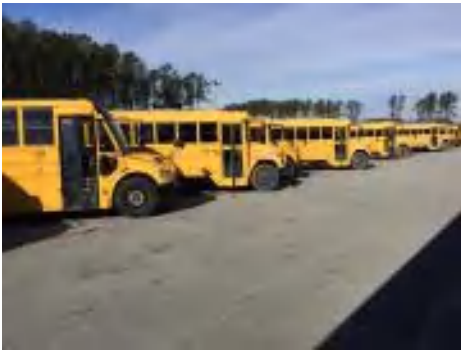
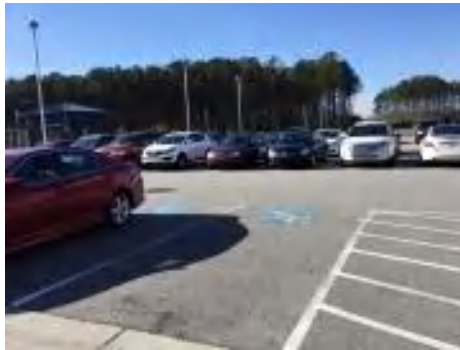
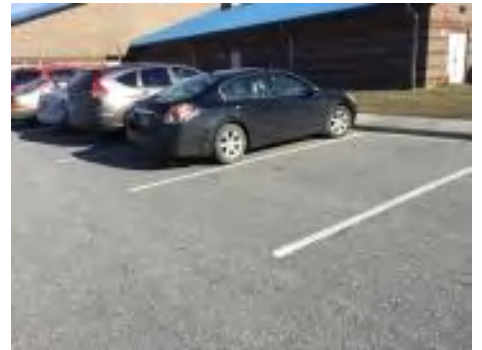
System: G2020 - Parking Lots

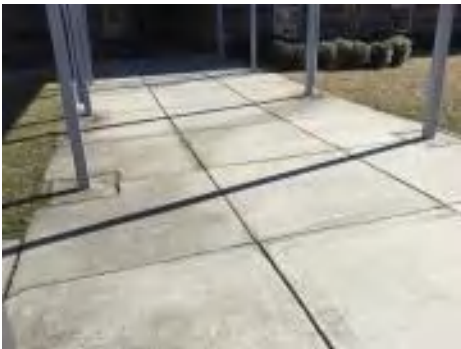
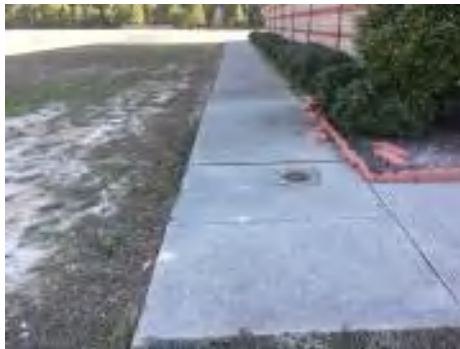
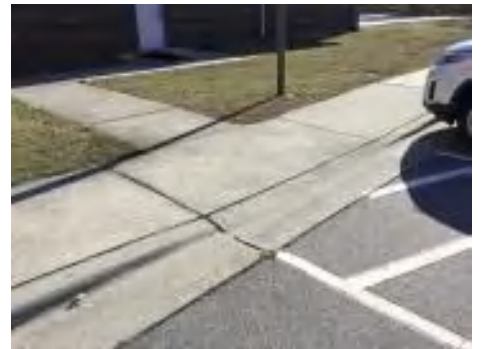
System: G2030 - Pedestrian Paving

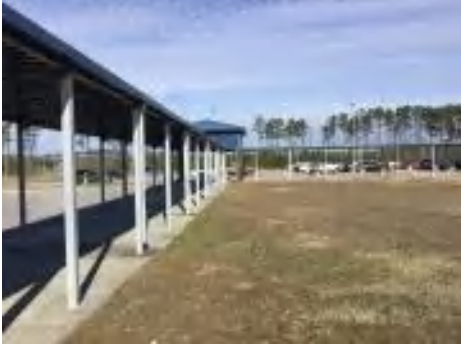
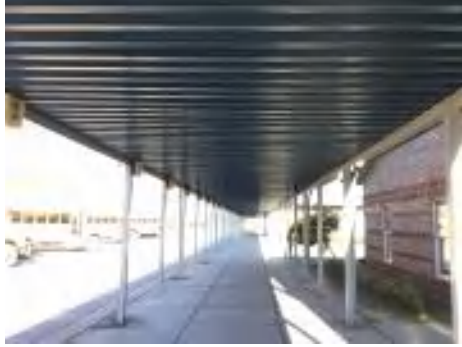
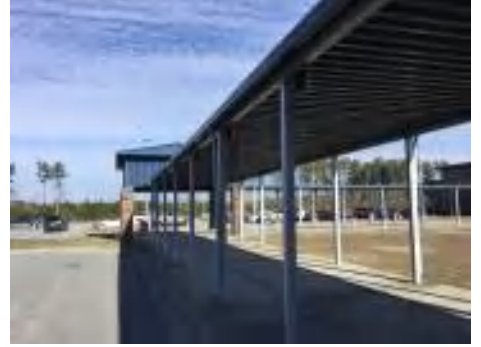
System: G2040950 - Covered Walkways

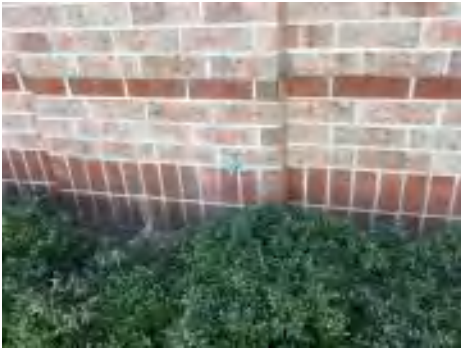
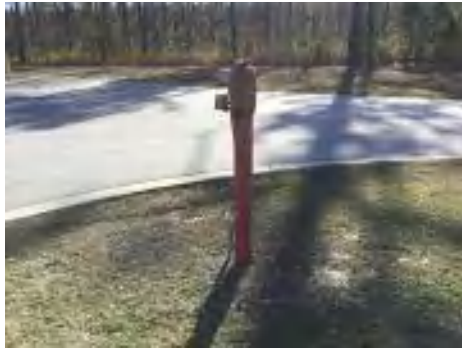
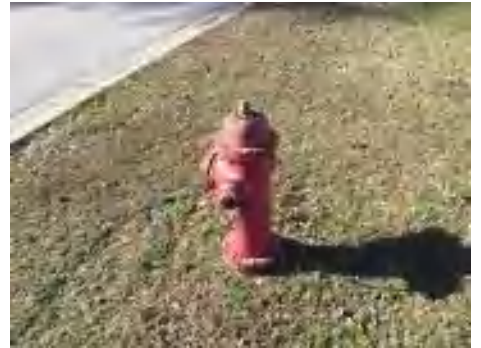
System: G3010 - Water Supply

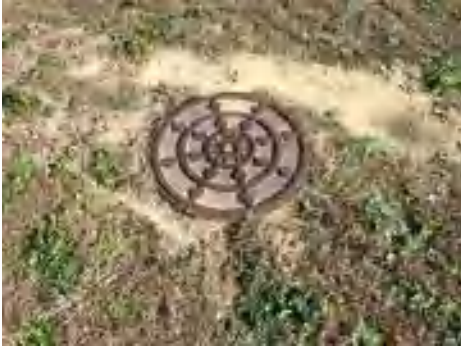
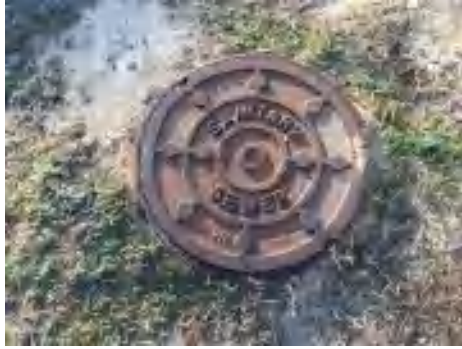
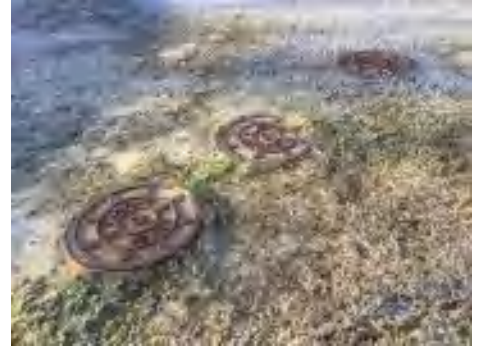
System: G3020 - Sanitary Sewer

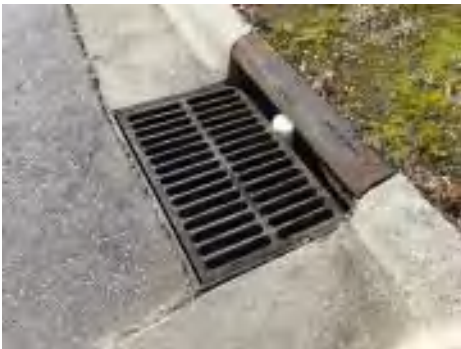
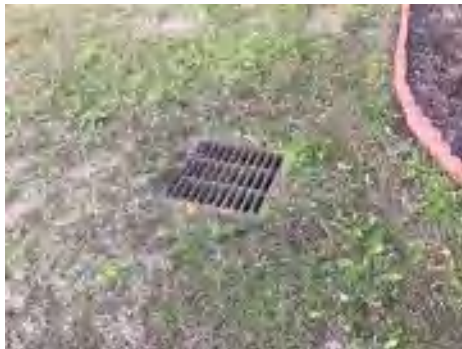
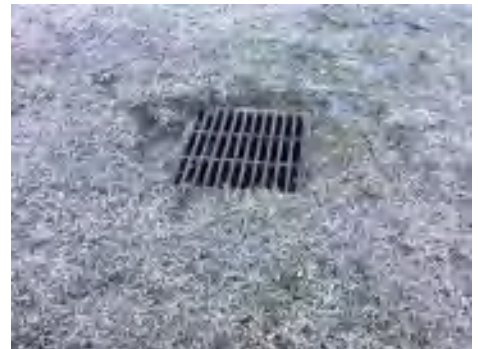
System: G3030 - Storm Sewer

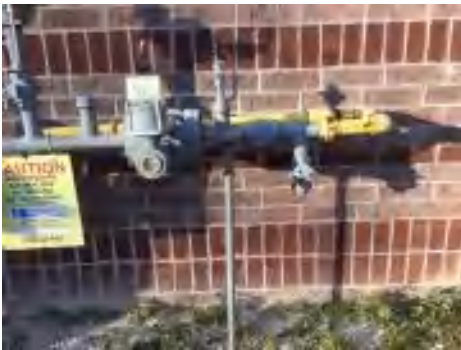
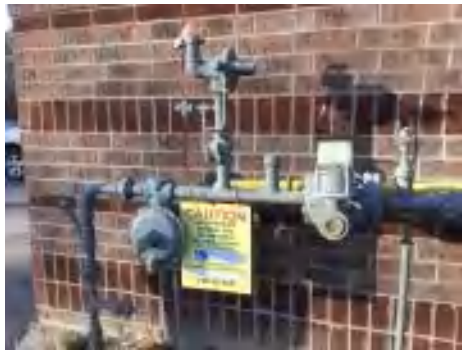
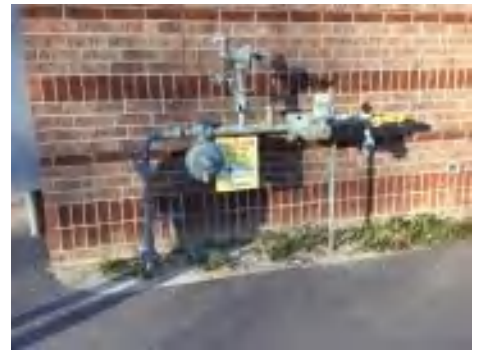
System: G3060 - Fuel Distribution

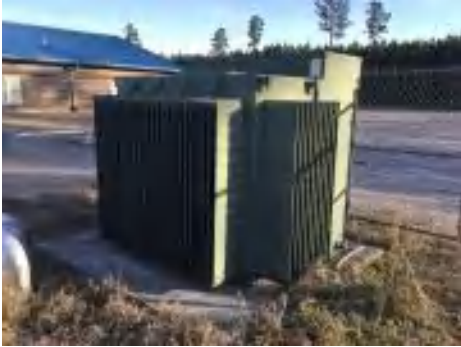
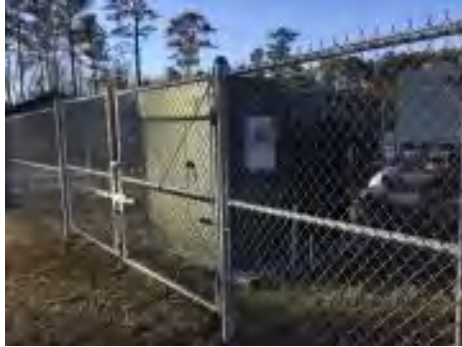
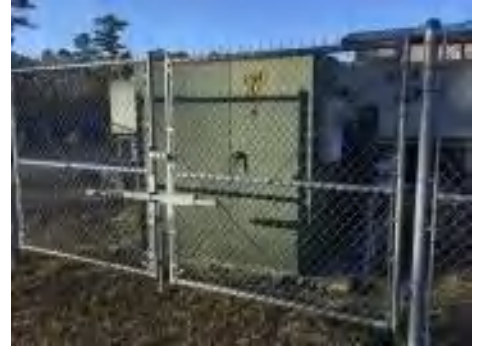
System: G4010 - Electrical Distribution

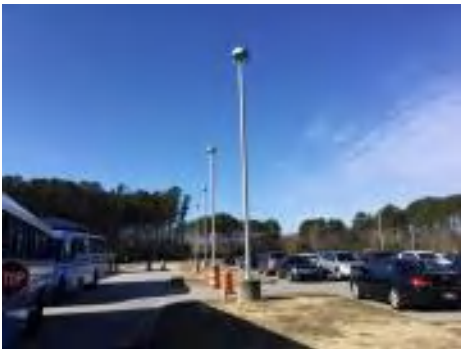
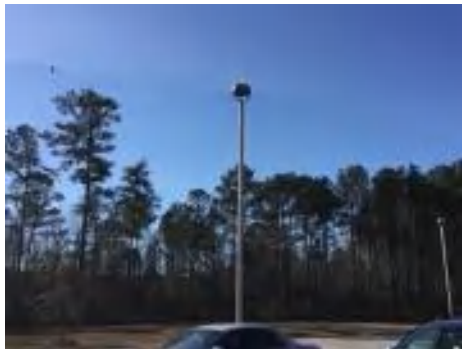
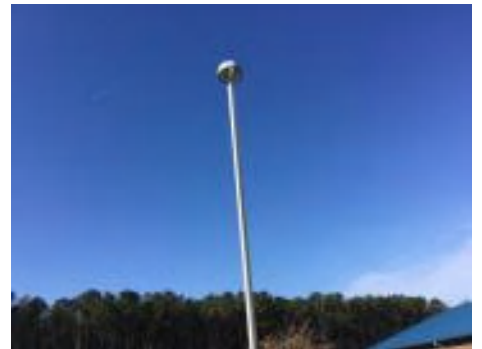
System: G4020 - Site Lighting

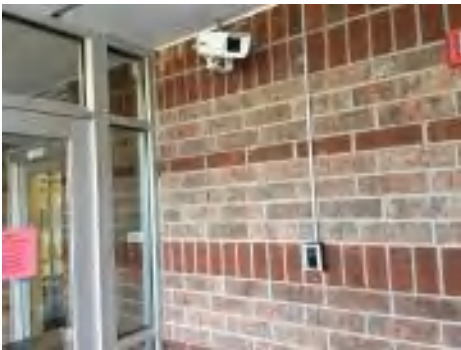
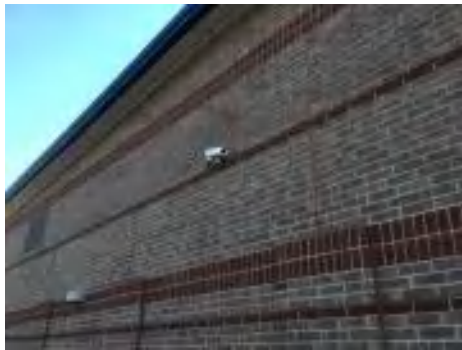
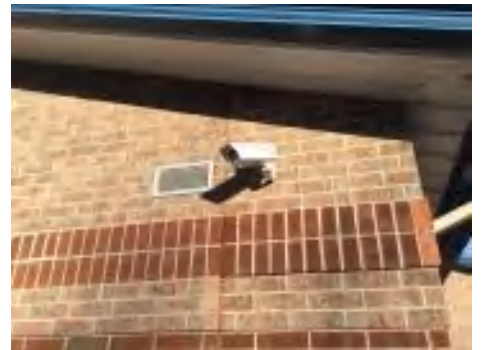
System: G4030 - Site Communications & Security

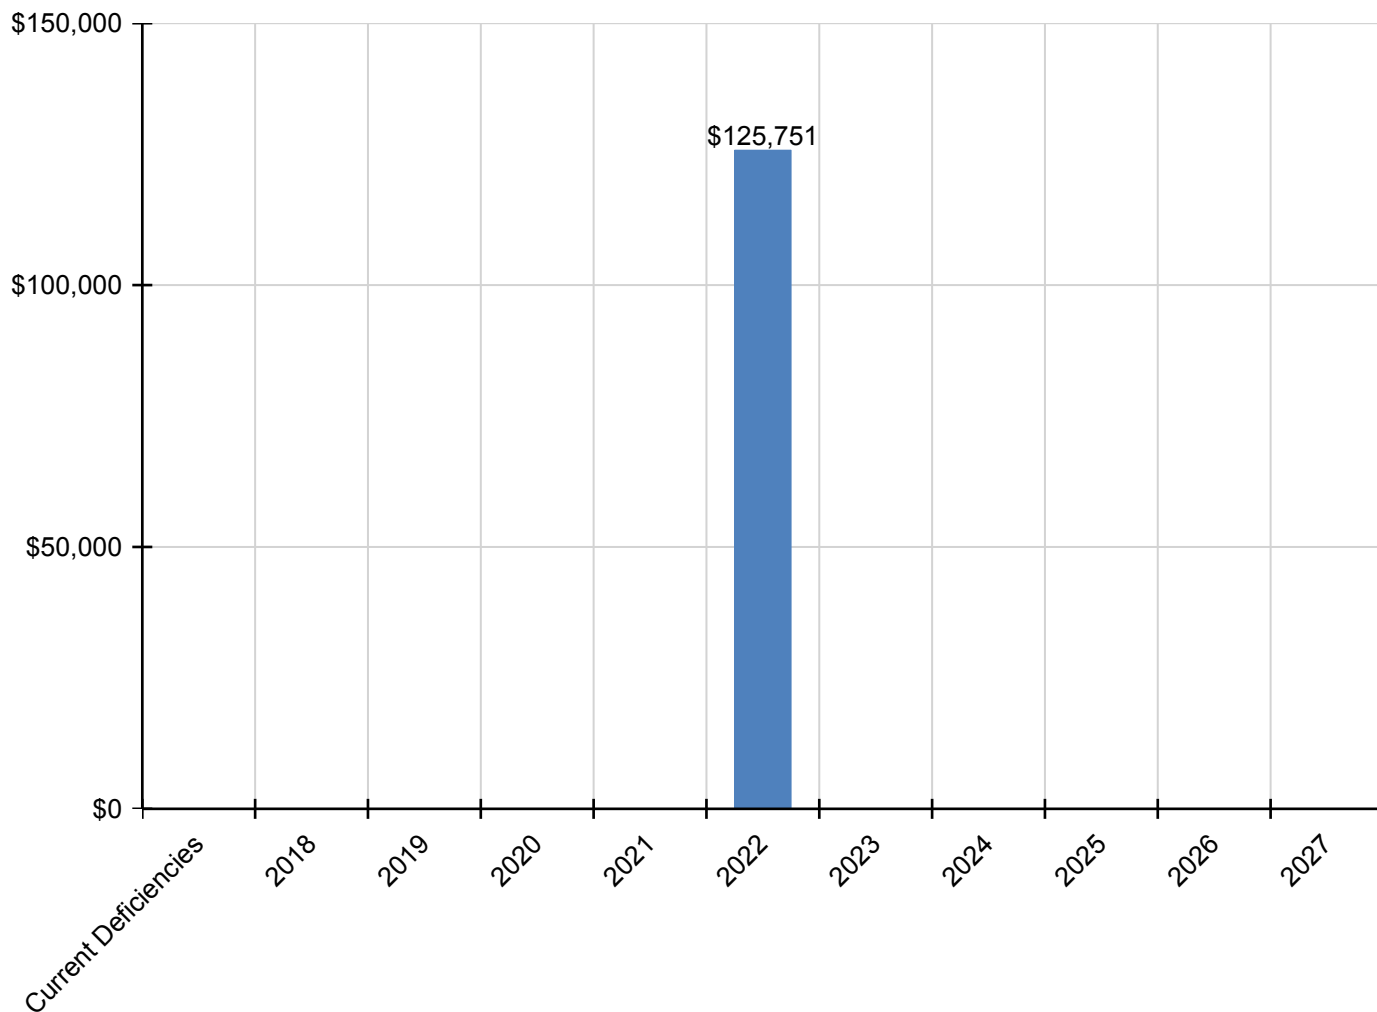
Forecasted Capital Renewal Requirement

The following chart shows the current building deficiencies and forecasting capital renewal or sustainment requirements over the next ten years.

eCOMET forecasts future Capital Renewal projects for expiring systems based on the Calculated Next Renewal year found in the system listing. There is a 3% yearly inflation factor applied to the system costs expiring in the future. The table below reflects Capital Renewal projects over the next 10 years. Note: Blank cells (or \$0) indicate no systems are scheduled for renewal in that year.

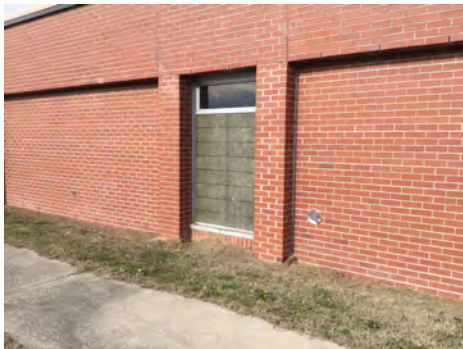
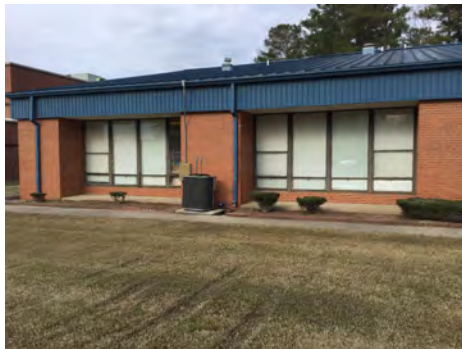
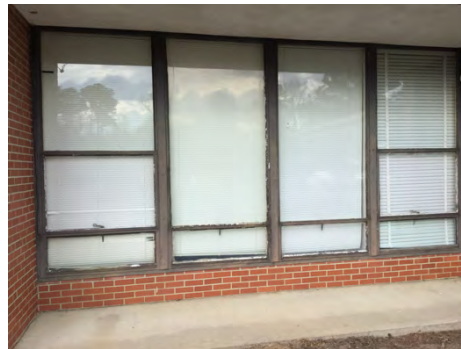
System: B2020 - Exterior Windows

Note: The exterior windows are beyond their service life and should be replaced.

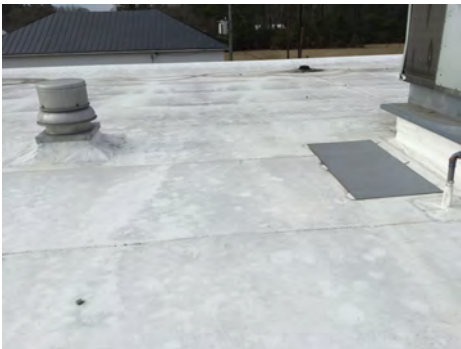
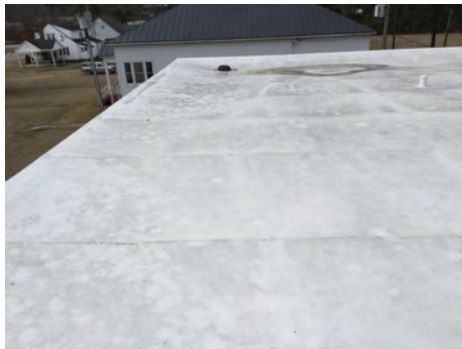
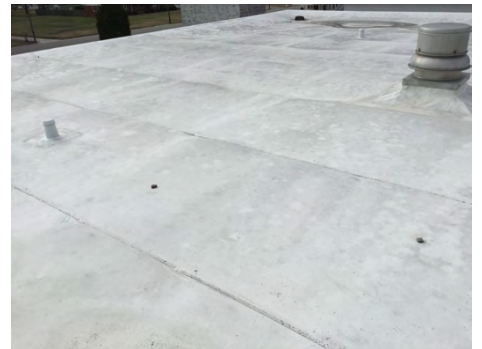
System: B3010120 - Single Ply Membrane

Note: The roof is beyond its service life and should be replaced.

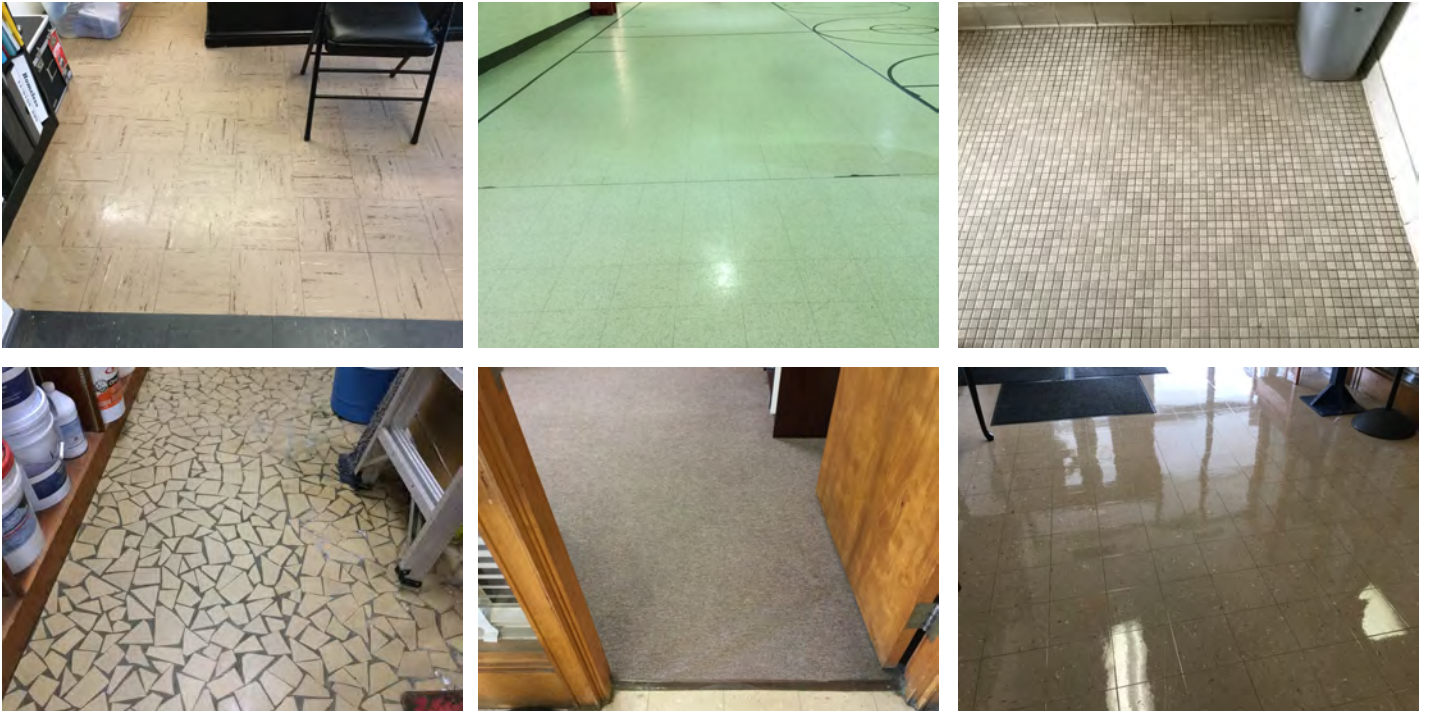
System: C3020 - Floor Finishes

Note: Some VCT and all the carpet needs to be replaced.

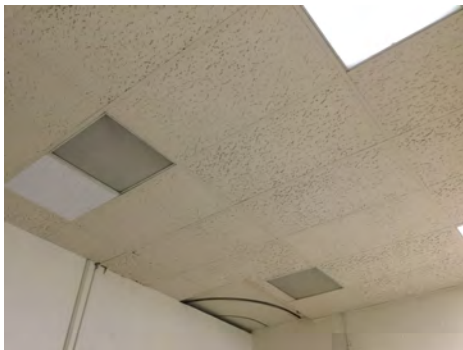
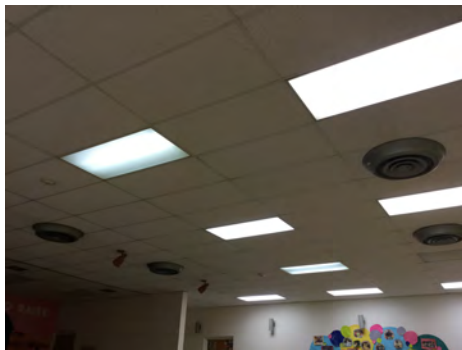
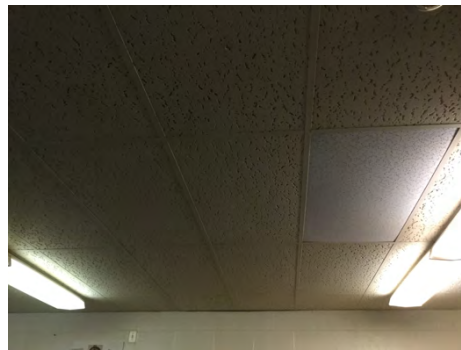
System: C3030 - Ceiling Finishes

Note: The ceiling finishes are beyond their service life and should be replaced.

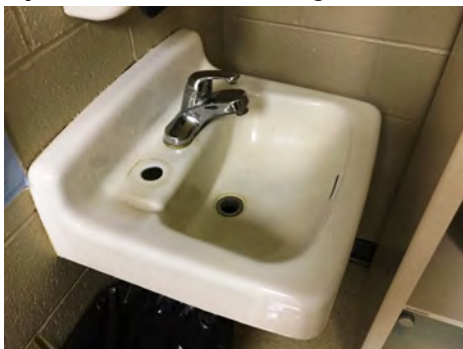
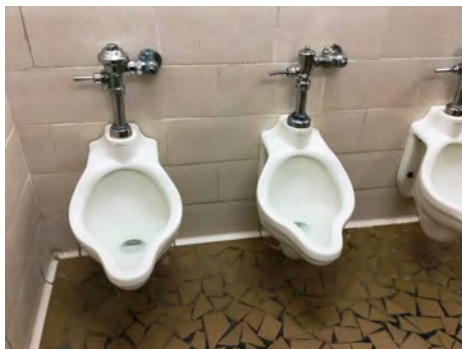
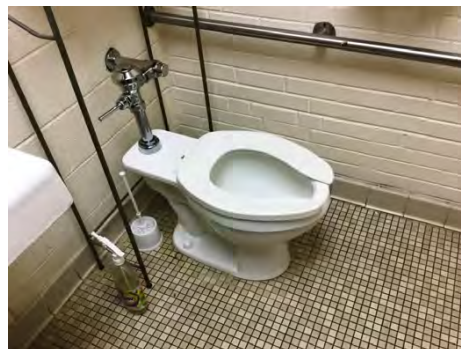
System: D2010 - Plumbing Fixtures

Note: The plumbing fixtures are beyond their service life and should be replaced.

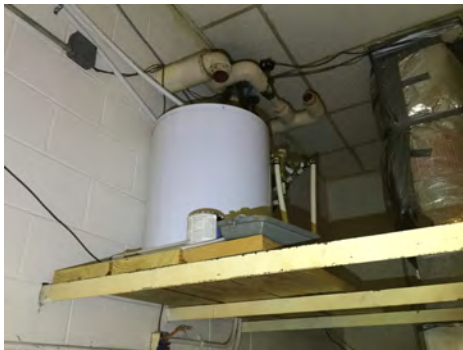
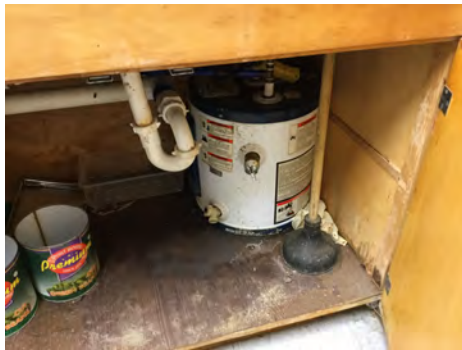
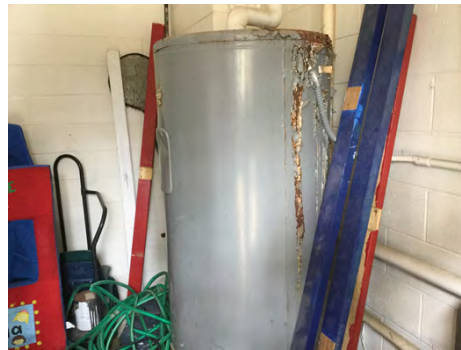
System: D2020 - Domestic Water Distribution

Note: The water distribution system is beyond its service life and should be replaced.

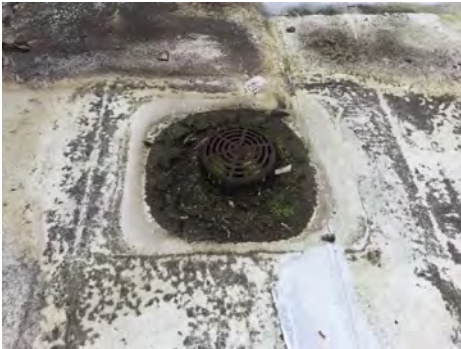
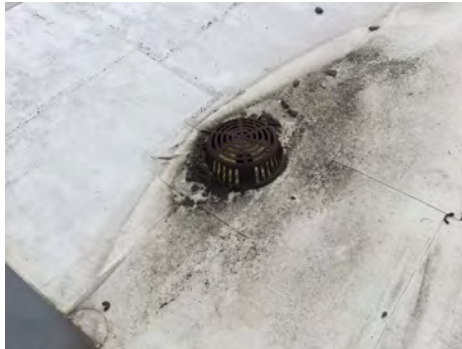
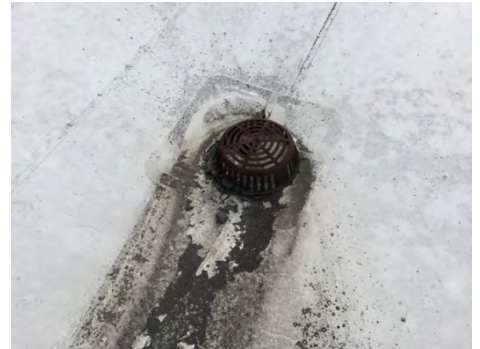
System: D2040 - Rain Water Drainage

Note: The rain water drainage system is beyond its service life and should be replaced.

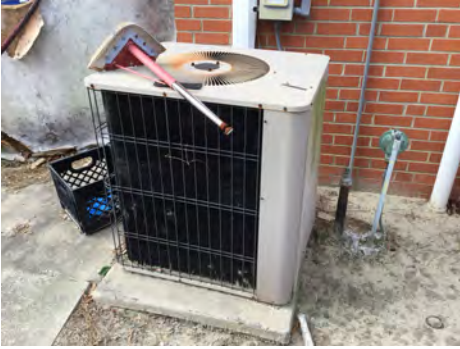
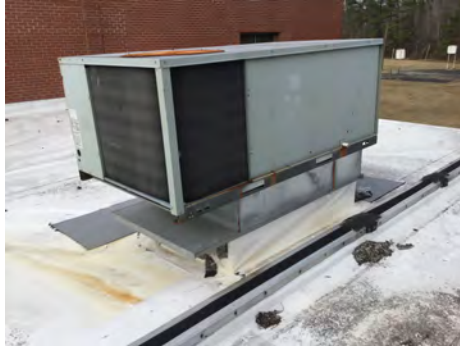
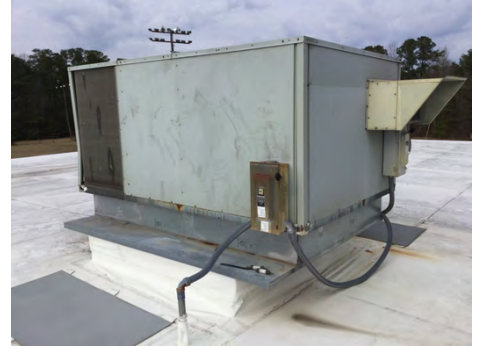
System: D3050 - Terminal & Package Units

Note: The terminal and package units are beyond their service life and should be replaced.

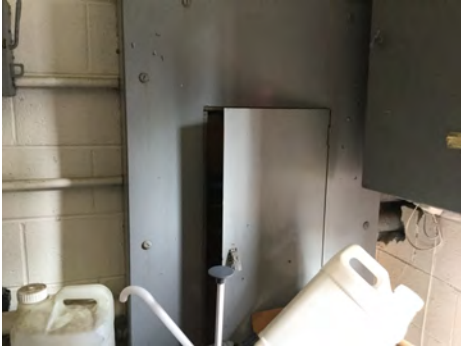
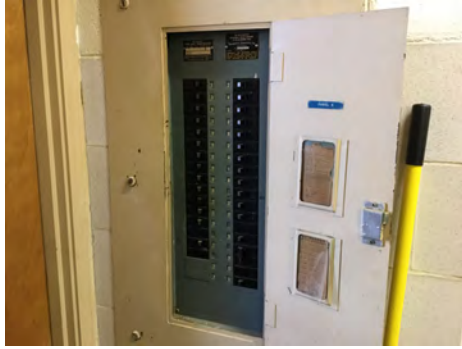
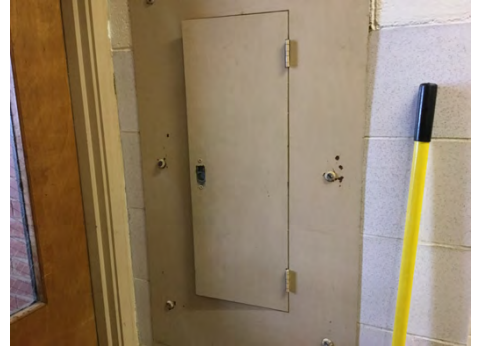
System: D5020 - Branch Wiring

Note: The branch wiring system is beyond its service life and should be replaced.

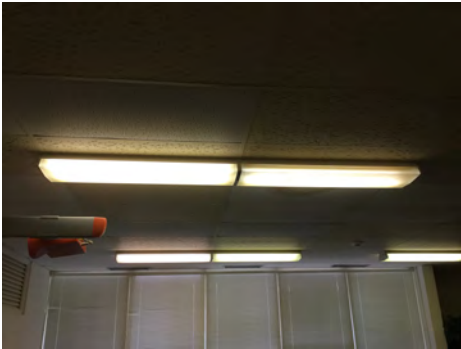
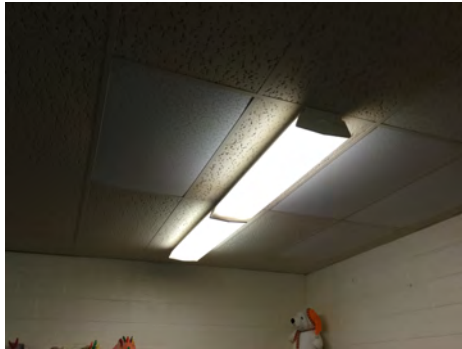
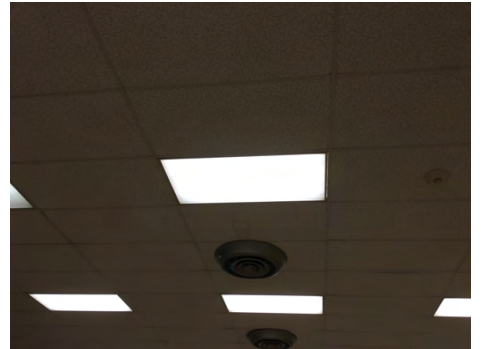
System: D5020 - Lighting

Note: The lighting fixtures are beyond their service life and should be replaced.

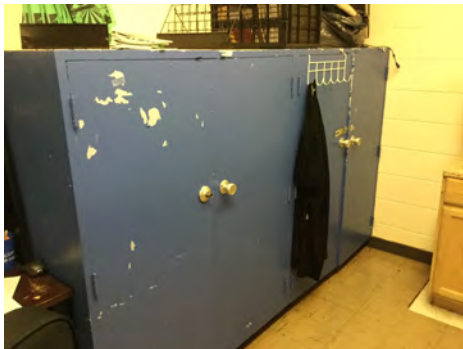
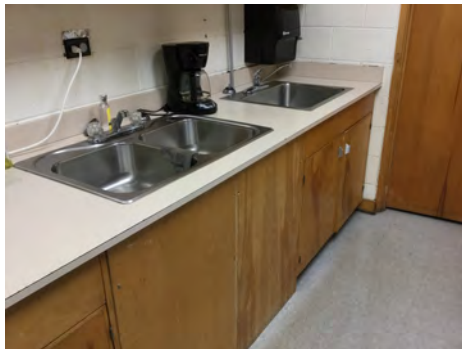
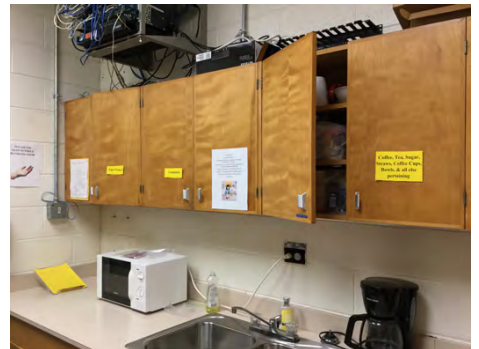
System: E2010 - Fixed Furnishings

Note: The fixed furnishings are beyond their service life and should be replaced.

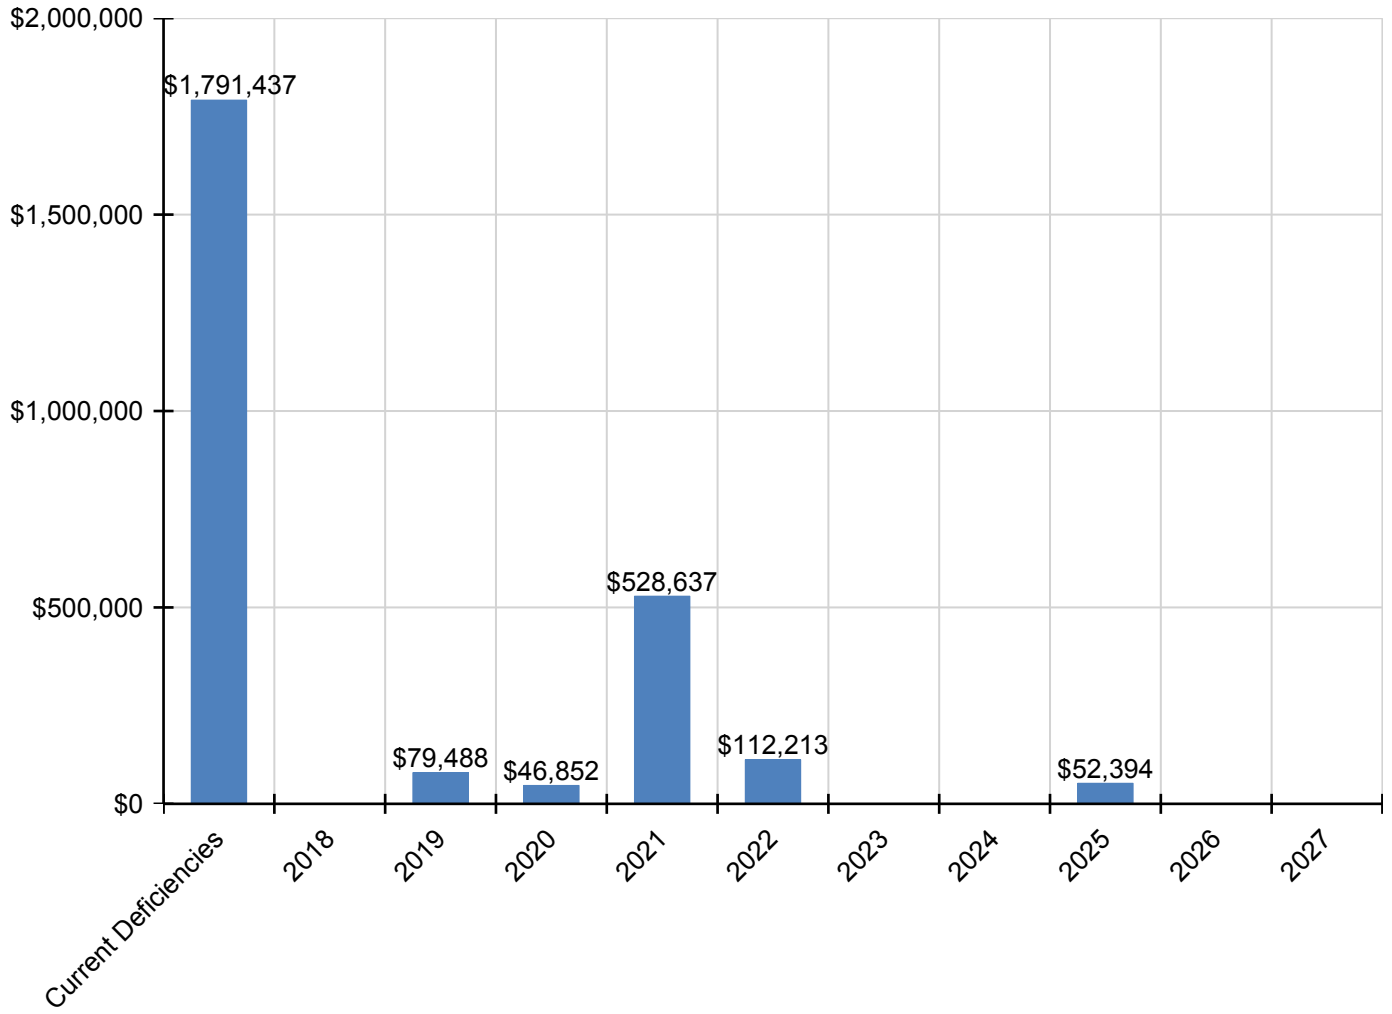
Forecasted Capital Renewal Requirement

The following chart shows the current building deficiencies and forecasting capital renewal or sustainment requirements over the next ten years.

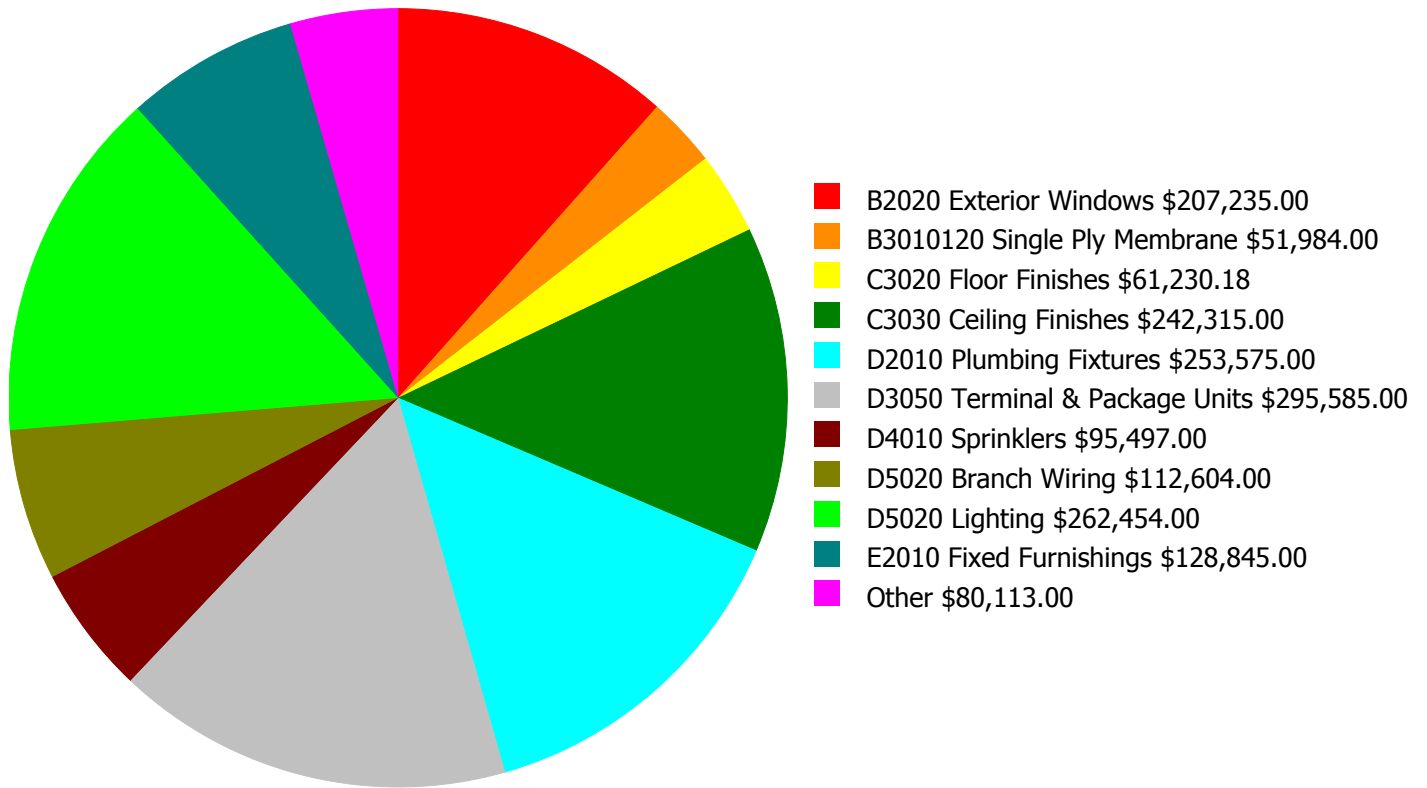
Deficiency Summary by System

Current deficiencies included assemblies that have reached or exceeded their design life or components of the assemblies that are in need of repair. Assemblies that have reached their design life are identified as current deficiencies and assigned the distress 'Beyond Useful Life'. The following chart lists all current deficiencies associated with this facility.
