NC School District/080 Bertie County/Middle School

Bertie Middle

Campus Assessment Report

March 8, 2017

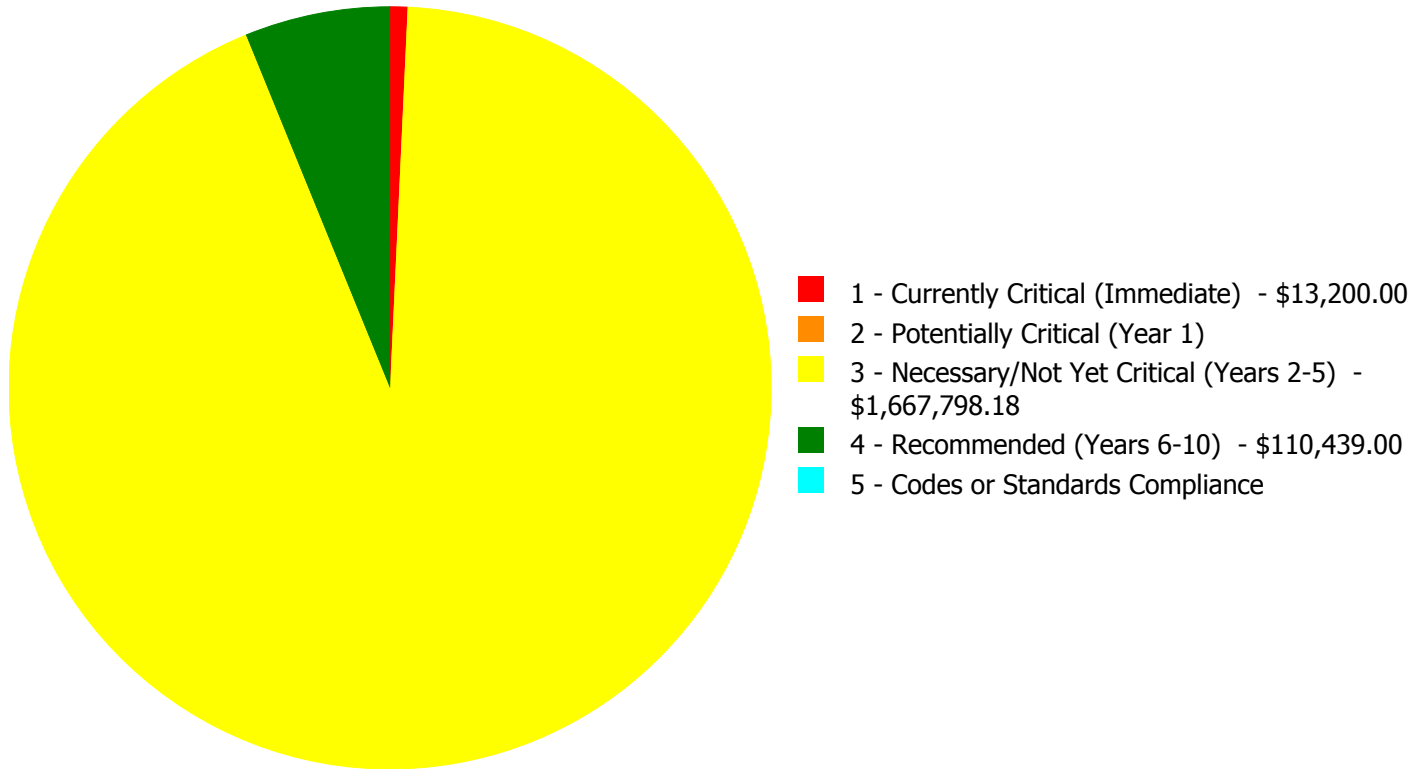
Deficiency Summary by Priority

The following chart shows the total repair costs broken down by priority. Assessors assigned deficiencies within eCOMET to one of the following priority categories:

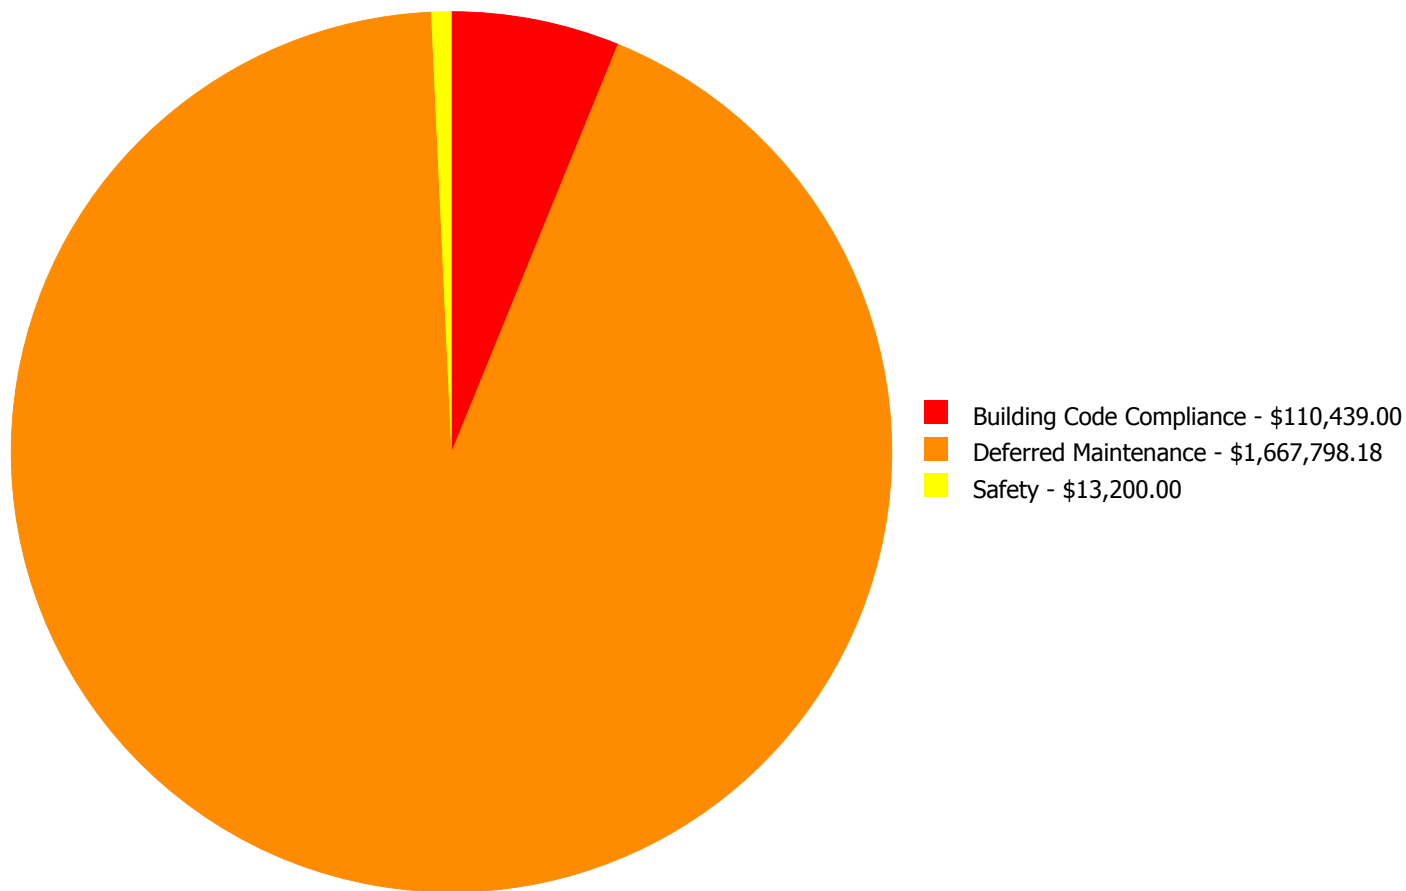
Deficiency Summary by Category

The following chart shows the total repair costs broken down by deficiency categories. Assessors assigned deficiencies to one of the following categories:

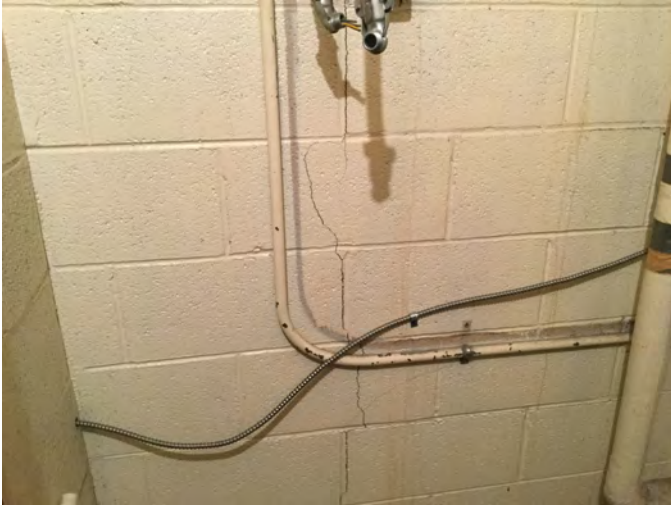
System: C1010 - Partitions

Location: Throughout the building
Distress: Failing
Category: Safety
Priority: 1 - Currently Critical (Immediate)
Correction: Engineering Study
Qty: 1.00
Unit of Measure: Ea.
Estimate: \$13,200.00
Assessor Name: Eduardo Lopez
Date Created: 02/03/2017

Notes: There are visible cracks on the partition wall which should be studied by a professional engineer.

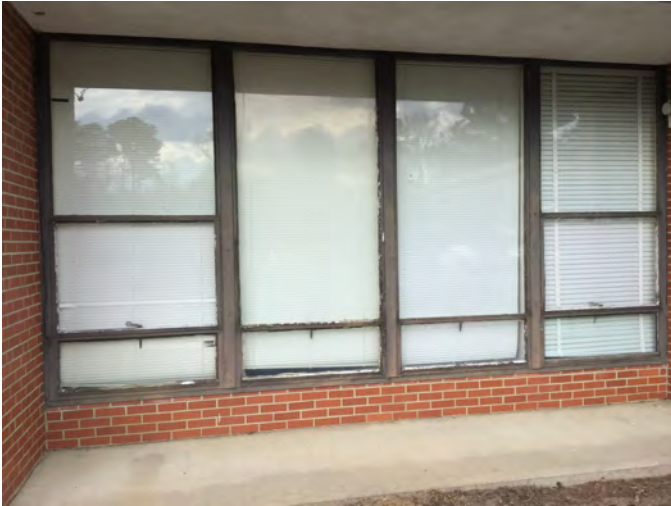
System: B2020 - Exterior Windows

Location: Exterior Walls
Distress: Beyond Service Life
Category: Deferred Maintenance
Priority: 3 - Necessary/Not Yet Critical (Years 2-5)
Correction: Renew System
Qty: 19,686.00
Unit of Measure: S.F.
Estimate: \$207,235.00
Assessor Name: Eduardo Lopez
Date Created: 02/06/2017

Notes: The exterior windows are beyond their service life and should be replaced.

Note: The exterior windows are beyond their service life and should be replaced.

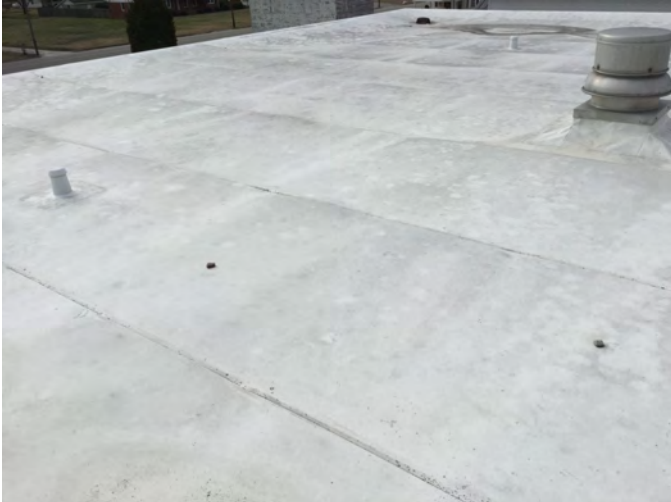
System: B3010120 - Single Ply Membrane

Location: Roof
Distress: Beyond Service Life
Category: Deferred Maintenance
Priority: 3 - Necessary/Not Yet Critical (Years 2-5)
Correction: Renew System
Qty: 4,965.00
Unit of Measure: S.F.
Estimate: \$51,984.00
Assessor Name: Eduardo Lopez
Date Created: 02/06/2017

Notes: The roof is beyond its service life and should be replaced.

Note: The roof is beyond its service life and should be replaced.

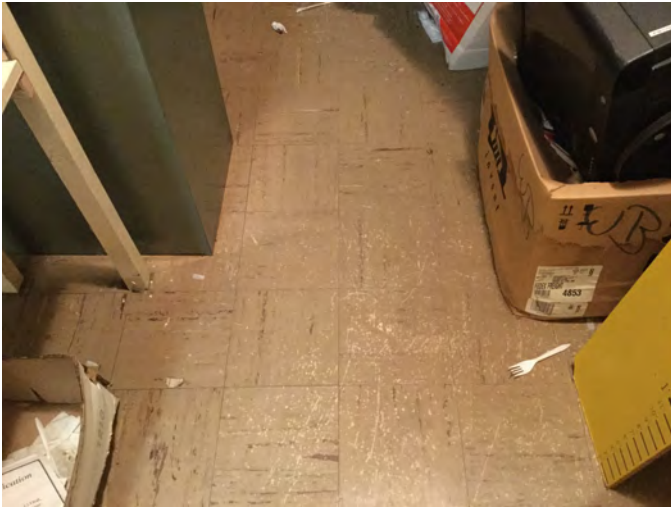
System: C3020 - Floor Finishes

Location: Gymnasium and storage areas
Distress: Beyond Service Life
Category: Deferred Maintenance
Priority: 3 - Necessary/Not Yet Critical (Years 2-5)
Correction: Replace vinyl tile flooring
Qty: 490.00
Unit of Measure: S.Y.
Estimate: \$52,681.86
Assessor Name: Eduardo Lopez
Date Created: 02/03/2017

Notes: The vinyl tiles are cracked and should be replaced, the other areas have suspected material and it should be abated and replaced.

Note: Some VCT and all the carpet needs to be replaced.

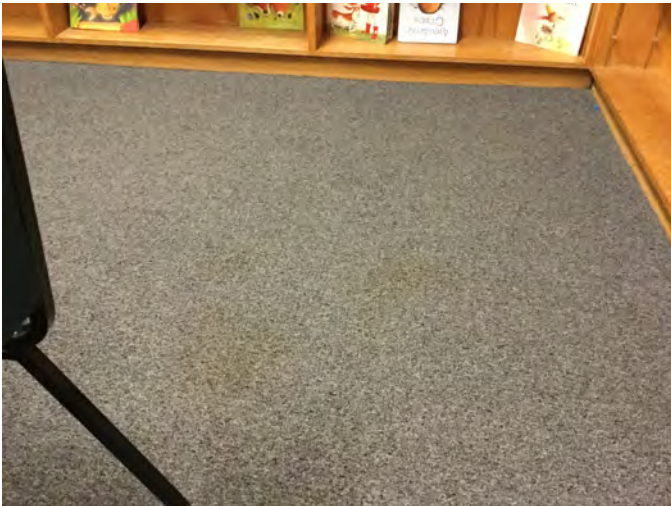
System: C3020 - Floor Finishes

Location: Throughout the building
Distress: Beyond Service Life
Category: Deferred Maintenance
Priority: 3 - Necessary/Not Yet Critical (Years 2-5)
Correction: Replace carpet
Qty: 100.00
Unit of Measure: S.Y.
Estimate: \$8,548.32
Assessor Name: Eduardo Lopez
Date Created: 02/03/2017

Notes: The carpet is beyond its service life and should be replaced.

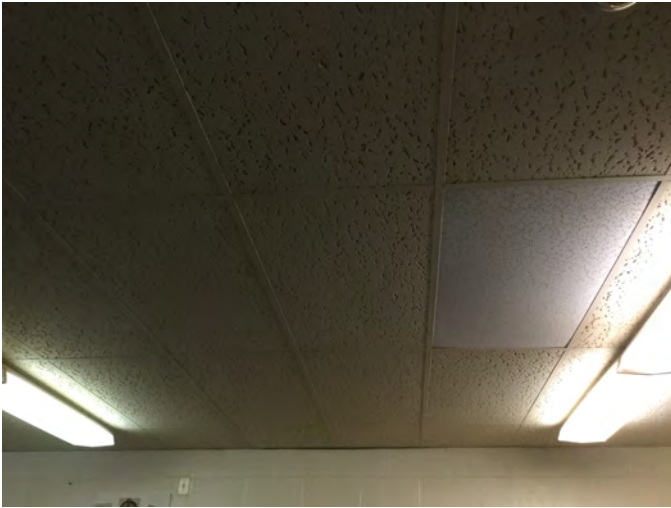
System: C3030 - Ceiling Finishes

Location: Throughout Building
Distress: Beyond Service Life
Category: Deferred Maintenance
Priority: 3 - Necessary/Not Yet Critical (Years 2-5)
Correction: Renew System
Qty: 19,686.00
Unit of Measure: S.F.
Estimate: \$242,315.00
Assessor Name: Eduardo Lopez
Date Created: 02/06/2017

Notes: The ceiling finishes are beyond their service life and should be replaced.

Note: The ceiling finishes are beyond their service life and should be replaced.

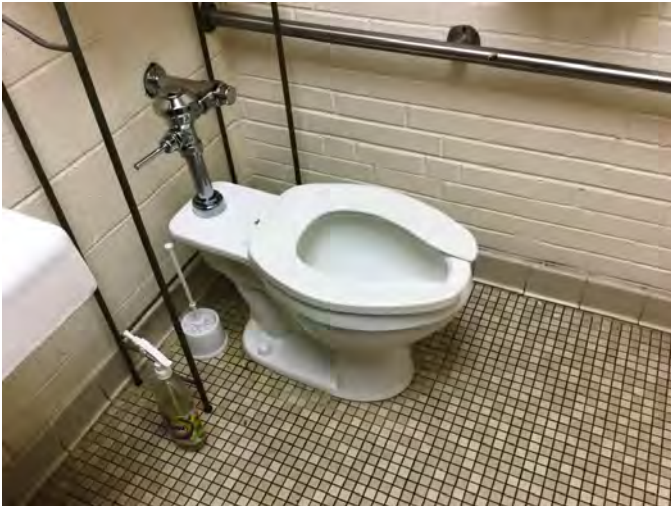
System: D2010 - Plumbing Fixtures

Location: Throughout Building
Distress: Beyond Service Life
Category: Deferred Maintenance
Priority: 3 - Necessary/Not Yet Critical (Years 2-5)
Correction: Renew System
Qty: 19,686.00
Unit of Measure: S.F.
Estimate: \$253,575.00
Assessor Name: Eduardo Lopez
Date Created: 02/06/2017

Notes: The plumbing fixtures are beyond their service life and should be replaced.

Note: The plumbing fixtures are beyond their service life and should be replaced.

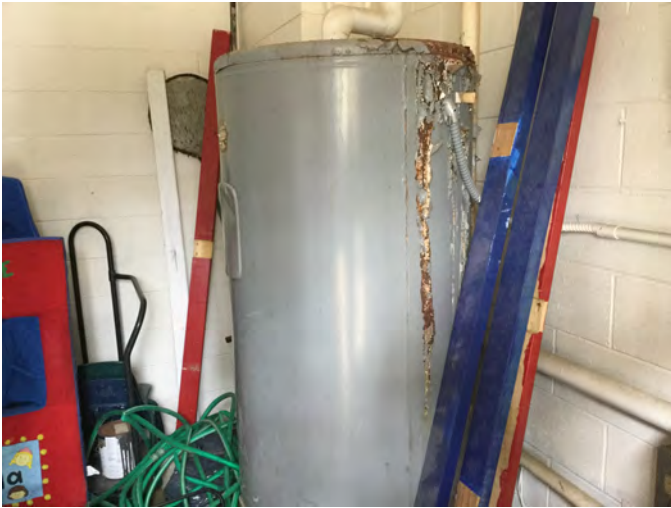
System: D2020 - Domestic Water Distribution

Location: Throughout Building
Distress: Beyond Service Life
Category: Deferred Maintenance
Priority: 3 - Necessary/Not Yet Critical (Years 2-5)
Correction: Renew System
Qty: 19,686.00
Unit of Measure: S.F.
Estimate: \$21,438.00
Assessor Name: Eduardo Lopez
Date Created: 02/06/2017

Notes: The water distribution system is beyond its service life and should be replaced.

Note: The water distribution system is beyond its service life and should be replaced.

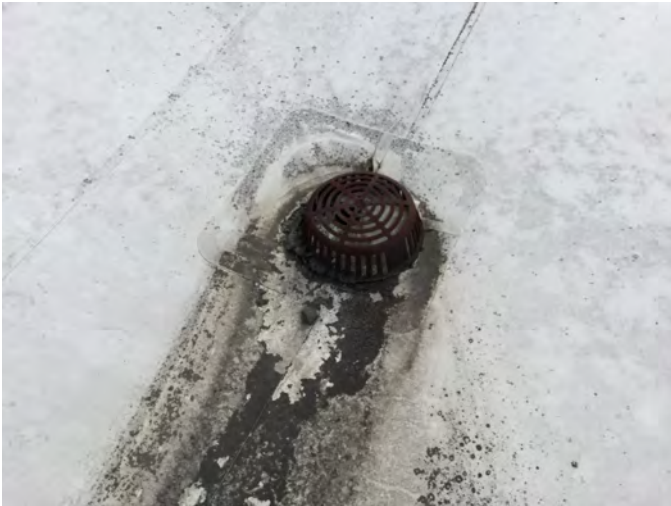
System: D2040 - Rain Water Drainage

Location: Roof
Distress: Beyond Service Life
Category: Deferred Maintenance
Priority: 3 - Necessary/Not Yet Critical (Years 2-5)
Correction: Renew System
Qty: 19,686.00
Unit of Measure: S.F.
Estimate: \$30,533.00
Assessor Name: Eduardo Lopez
Date Created: 02/06/2017

Notes: The rain water drainage system is beyond its service life and should be replaced.

Note: The rain water drainage system is beyond its service life and should be replaced.

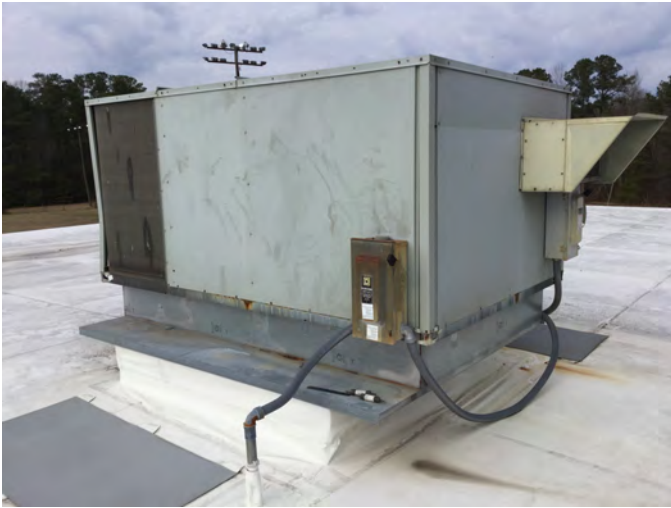
System: D3050 - Terminal & Package Units

Location: Throughout Building
Distress: Beyond Service Life
Category: Deferred Maintenance
Priority: 3 - Necessary/Not Yet Critical (Years 2-5)
Correction: Renew System
Qty: 19,686.00
Unit of Measure: S.F.
Estimate: \$295,585.00
Assessor Name: Eduardo Lopez
Date Created: 02/06/2017

Notes: The terminal and package units are beyond their service life and should be replaced.

Note: The terminal and package units are beyond their service life and should be replaced.

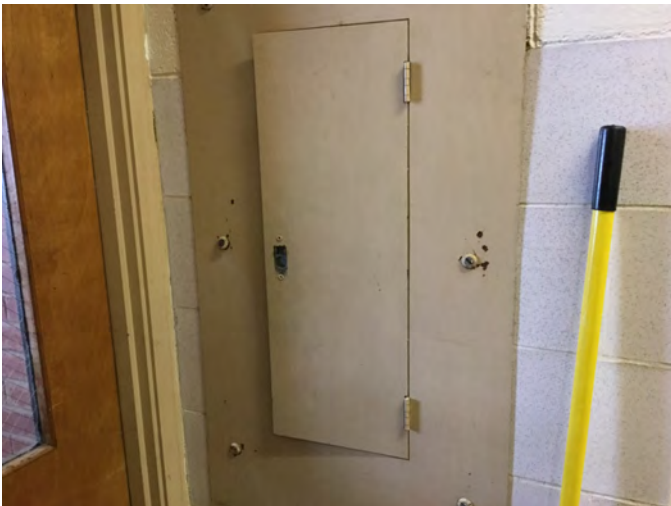
System: D5020 - Branch Wiring

Location: Throughout Building
Distress: Beyond Service Life
Category: Deferred Maintenance
Priority: 3 - Necessary/Not Yet Critical (Years 2-5)
Correction: Renew System
Qty: 19,686.00
Unit of Measure: S.F.
Estimate: \$112,604.00
Assessor Name: Eduardo Lopez
Date Created: 02/06/2017

Notes: The branch wiring system is beyond its service life and should be replaced.

Note: The branch wiring system is beyond its service life and should be replaced.

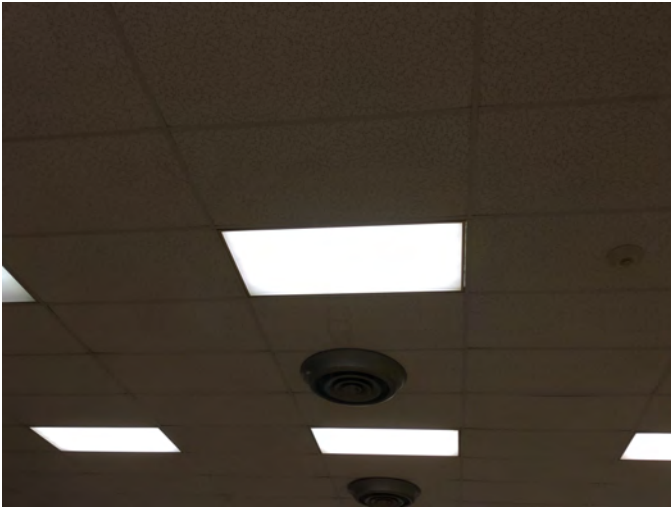
System: D5020 - Lighting

Location: Throughout Building
Distress: Beyond Service Life
Category: Deferred Maintenance
Priority: 3 - Necessary/Not Yet Critical (Years 2-5)
Correction: Renew System
Qty: 19,686.00
Unit of Measure: S.F.
Estimate: \$262,454.00
Assessor Name: Eduardo Lopez
Date Created: 02/06/2017

Notes: The lighting fixtures are beyond their service life and should be replaced.

Note: The lighting fixtures are beyond their service life and should be replaced.

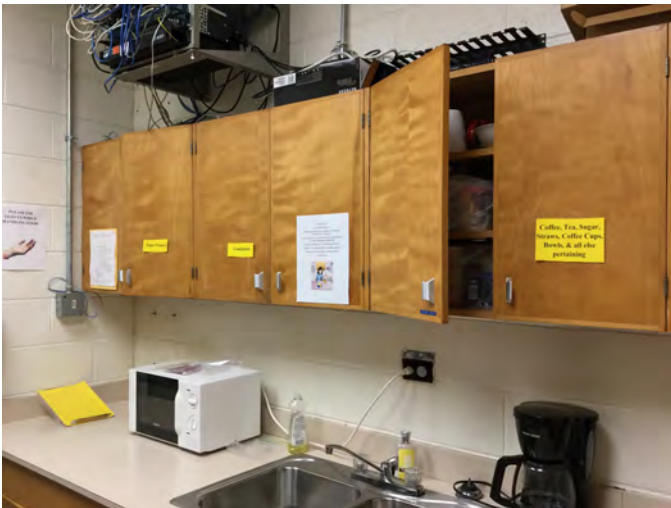
System: E2010 - Fixed Furnishings

Location: Throughout Building
Distress: Beyond Service Life
Category: Deferred Maintenance
Priority: 3 - Necessary/Not Yet Critical (Years 2-5)
Correction: Renew System
Qty: 19,686.00
Unit of Measure: S.F.
Estimate: \$128,845.00
Assessor Name: Eduardo Lopez
Date Created: 02/06/2017

Notes: The fixed furnishings are beyond their service life and should be replaced.

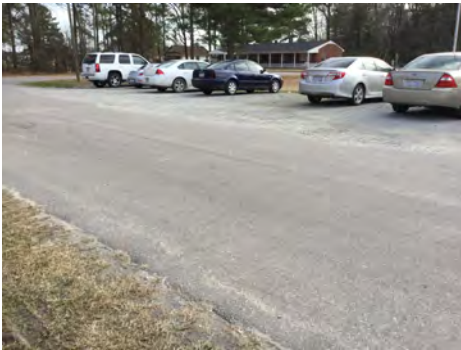
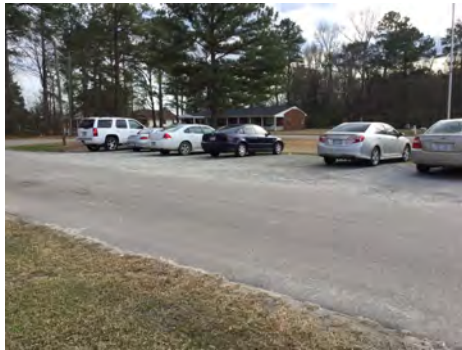
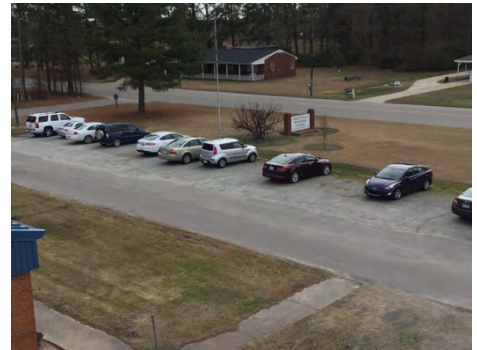
System: G2020 - Parking Lots

Note: The parking area is loose gravel and it needs to be paved and striped.

Notes: The parking area is loose gravel and it needs to paved and striped.

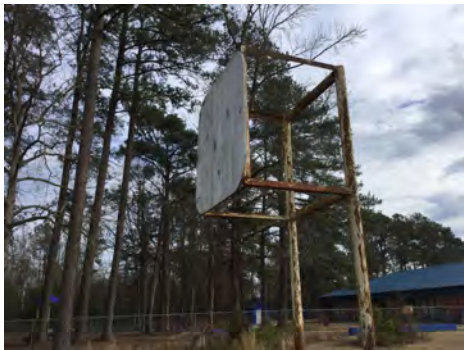
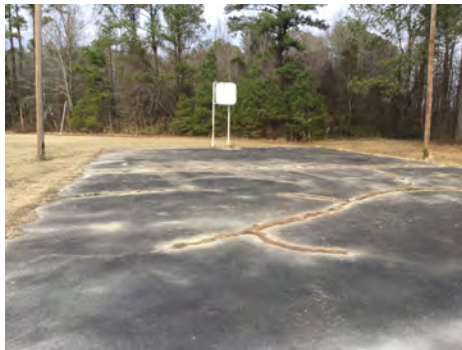
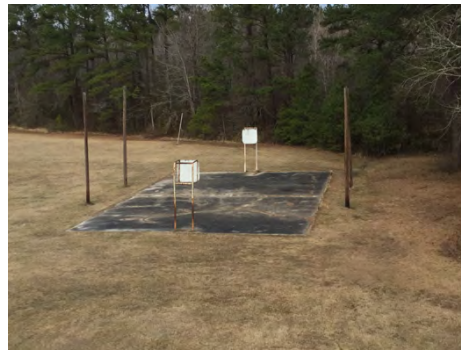
System: G2040950 - Hard Surface Play Area

Note: The hard surface play area is beyond its service life and should be replaced.

Notes: The hard surface play area is beyond its service life and should be replaced.

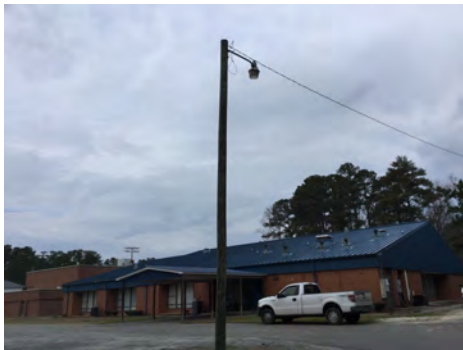
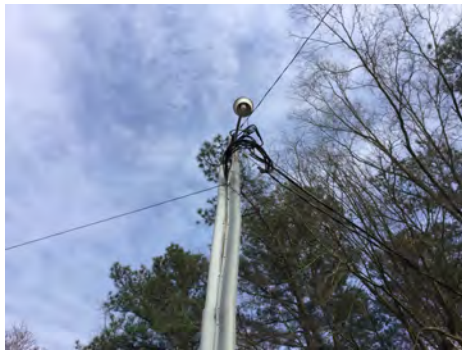
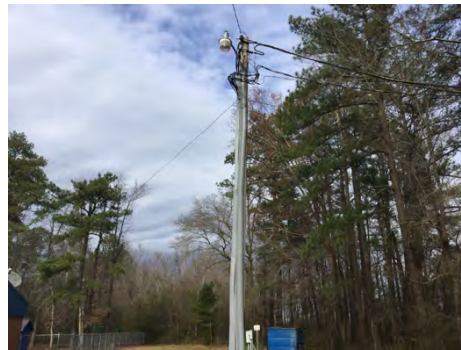
System: G4020 - Site Lighting

Note: The site lighting is beyond its service life and inadequate, more should be added and existing should be replaced.

Notes: The site lighting is beyond its service life and inadequate, more should be added and existing should be replaced.

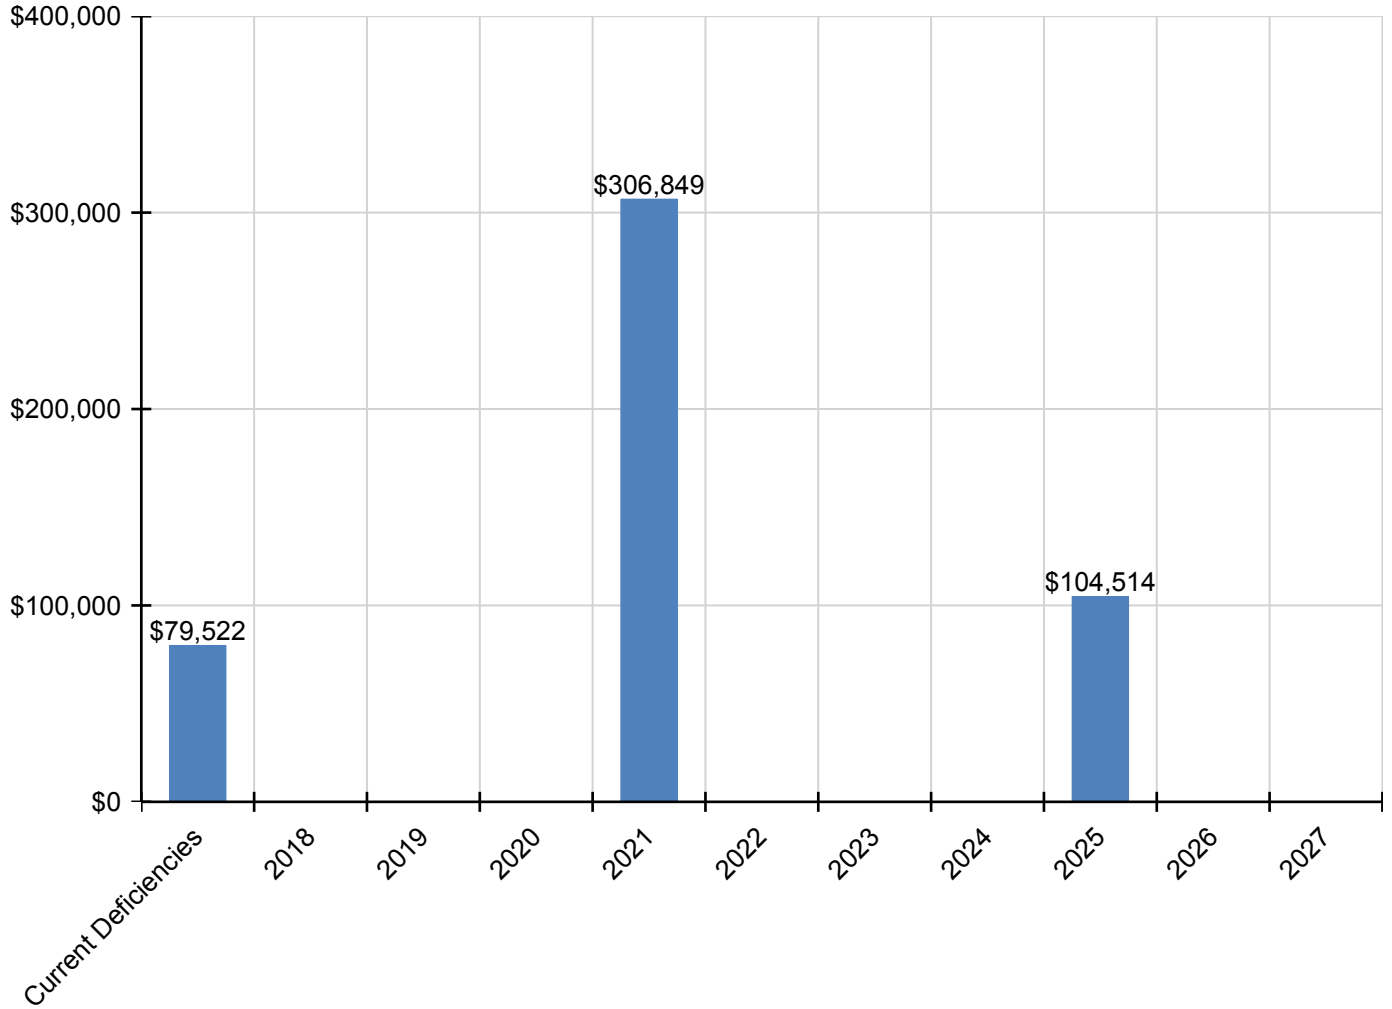
Forecasted Capital Renewal Requirement

The following chart shows the current building deficiencies and forecasting capital renewal or sustainment requirements over the next ten years.

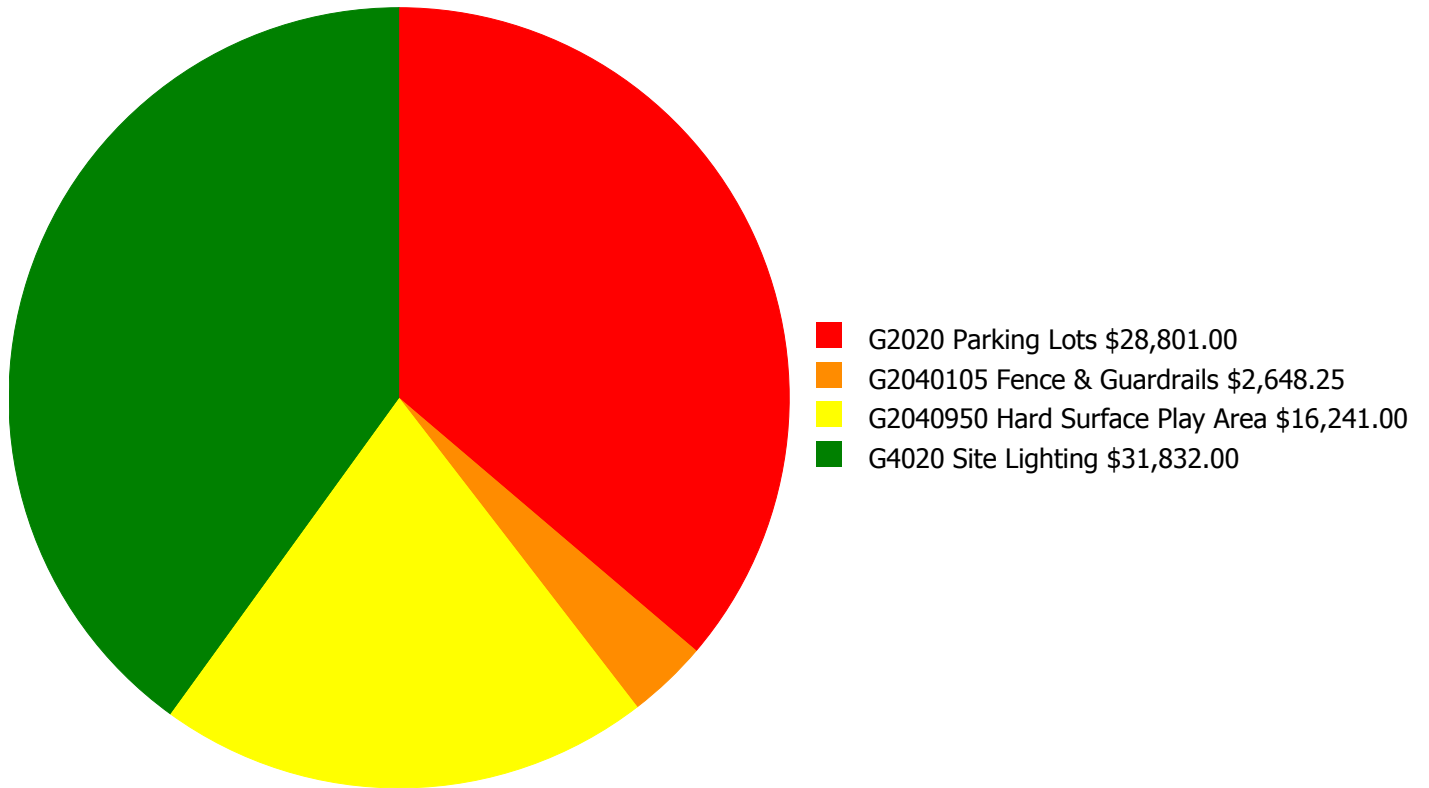
Deficiency Summary by System

Current deficiencies included assemblies that have reached or exceeded their design life or components of the assemblies that are in need of repair. Assemblies that have reached their design life are identified as current deficiencies and assigned the distress 'Beyond Useful Life'. The following chart lists all current deficiencies associated with this facility.

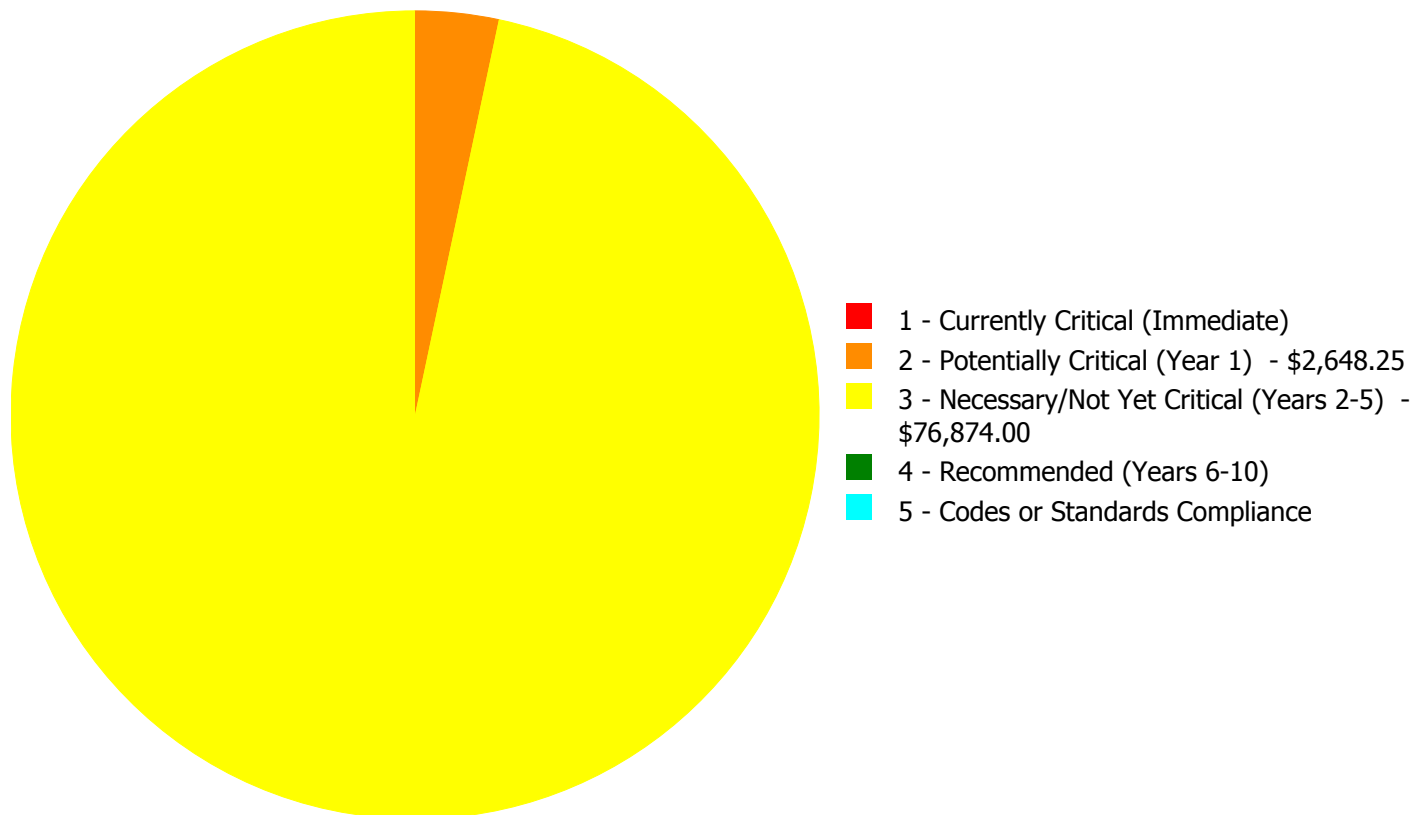
Deficiency Summary by Priority

The following chart shows the total repair costs broken down by priority. Assessors assigned deficiencies within eCOMET to one of the following priority categories:

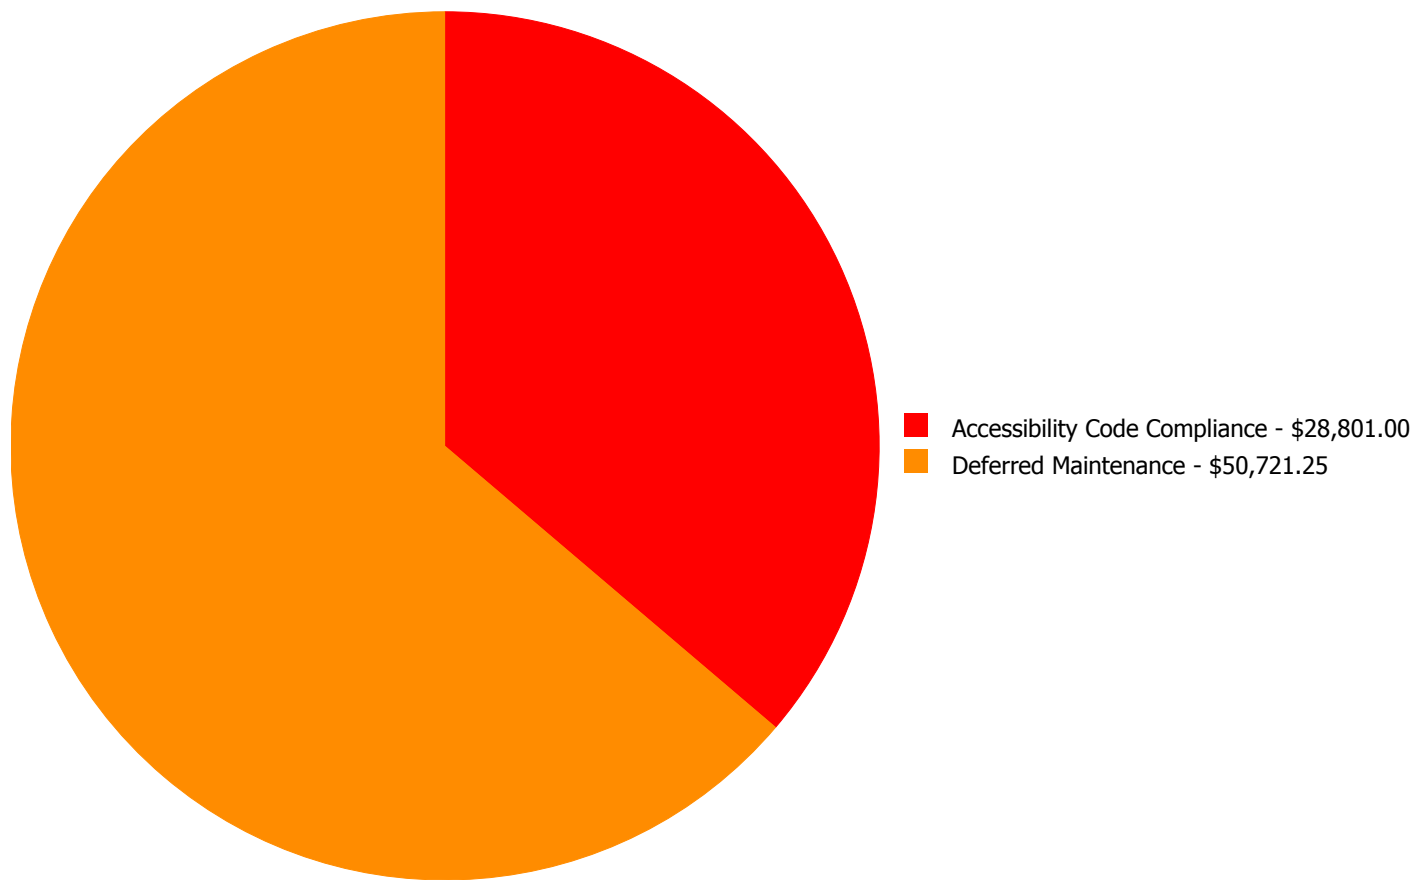
Deficiency Summary by Category

The following chart shows the total repair costs broken down by deficiency categories. Assessors assigned deficiencies to one of the following categories:

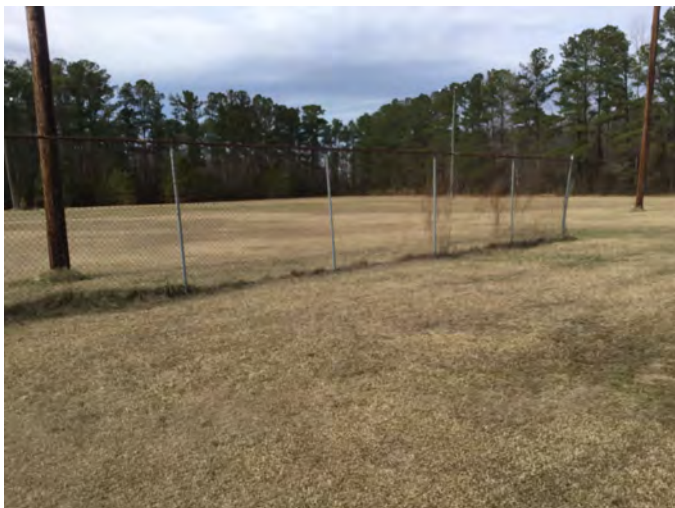
System: G2040105 - Fence & Guardrails

Location: Site
Distress: Beyond Service Life
Category: Deferred Maintenance
Priority: 2 - Potentially Critical (Year 1)
Correction: Install Chain Link Fence
Qty: 75.00
Unit of Measure: L.F.
Estimate: \$2,648.25
Assessor Name: Somnath Das
Date Created: 02/03/2017

Notes: The fence is in poor condition and should be replaced.

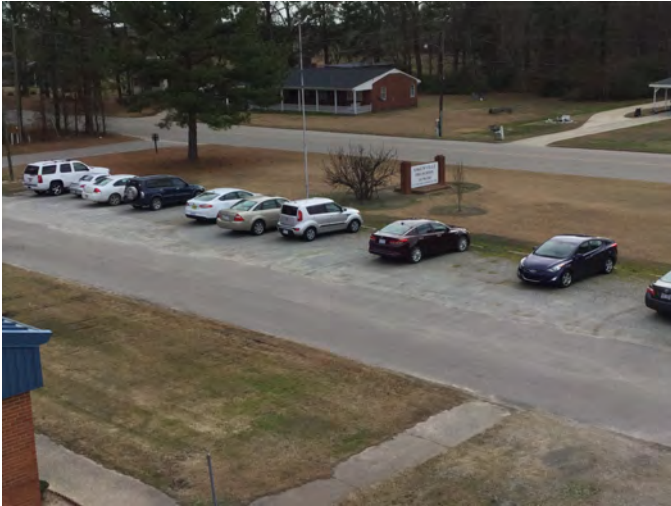
System: G2020 - Parking Lots

Location: Site
Distress: Inadequate
Category: Accessibility Code Compliance
Priority: 3 - Necessary/Not Yet Critical (Years 2-5)
Correction: Renew System
Qty: 19,686.00
Unit of Measure: S.F.
Estimate: \$28,801.00
Assessor Name: Somnath Das
Date Created: 02/06/2017

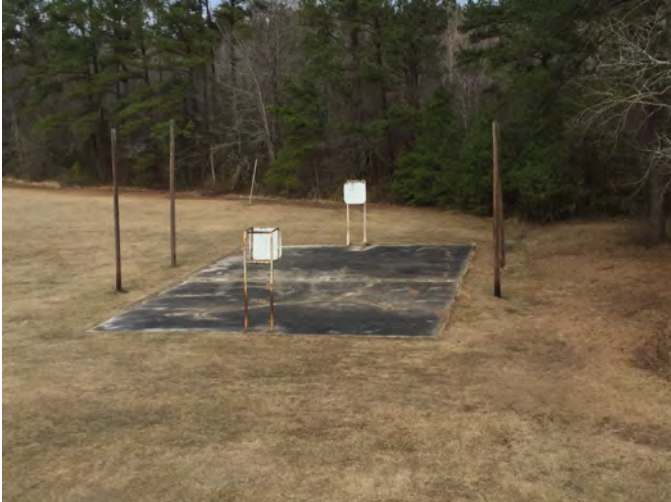
System: G2040950 - Hard Surface Play Area

Location: Site
Distress: Beyond Service Life
Category: Deferred Maintenance
Priority: 3 - Necessary/Not Yet Critical (Years 2-5)
Correction: Renew System
Qty: 19,686.00
Unit of Measure: S.F.
Estimate: \$16,241.00
Assessor Name: Somnath Das
Date Created: 02/06/2017

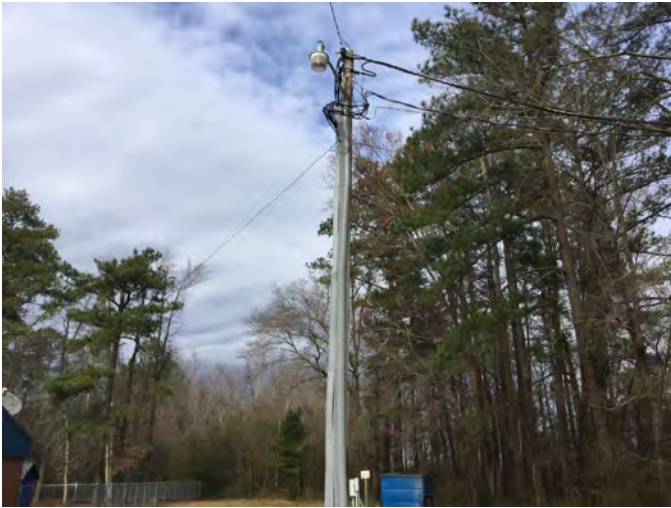
System: G4020 - Site Lighting

Location: Site
Distress: Beyond Service Life
Category: Deferred Maintenance
Priority: 3 - Necessary/Not Yet Critical (Years 2-5)
Correction: Renew System
Qty: 19,686.00
Unit of Measure: S.F.
Estimate: \$31,832.00
Assessor Name: Somnath Das
Date Created: 02/06/2017

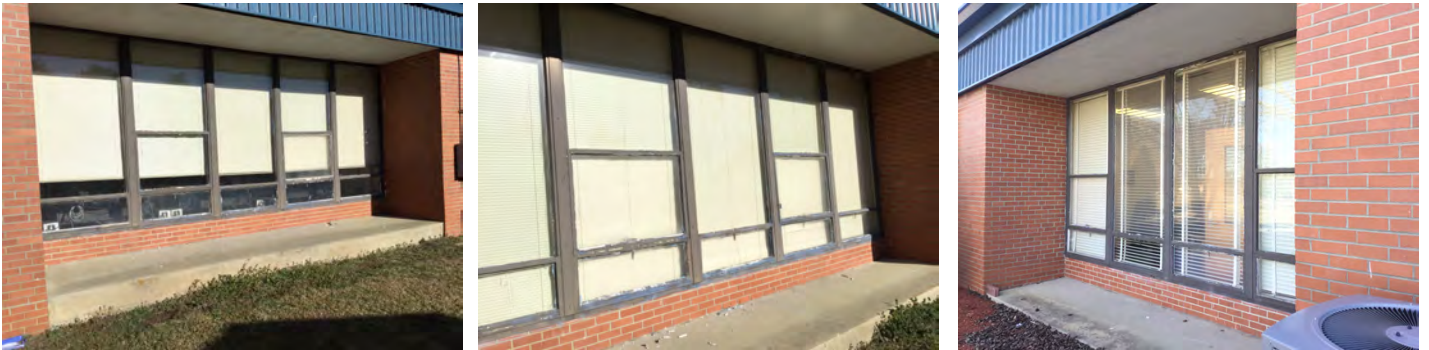
System: B2020 - Exterior Windows

Note: The exterior windows are beyond their service life and should be replaced.

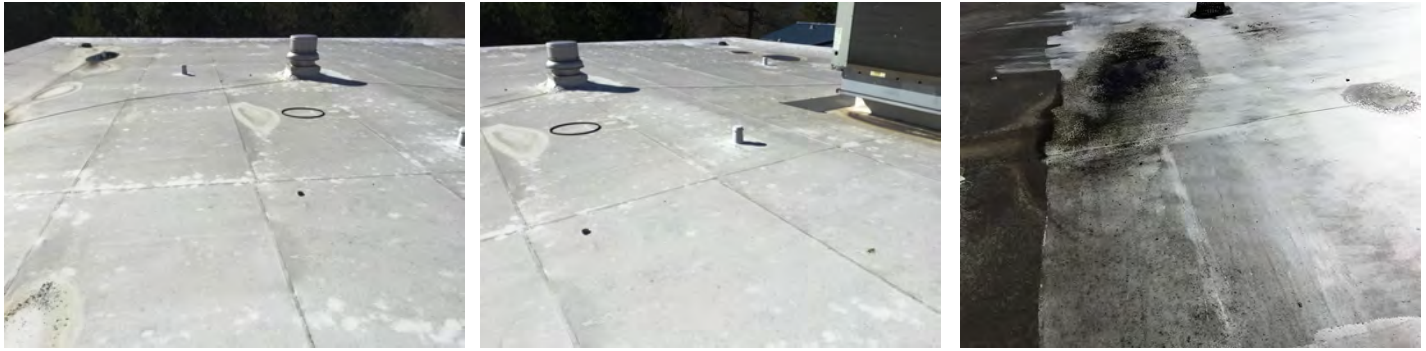
System: B3010120 - Single Ply Membrane

Note: The roof covering is in poor condition and should be replaced.

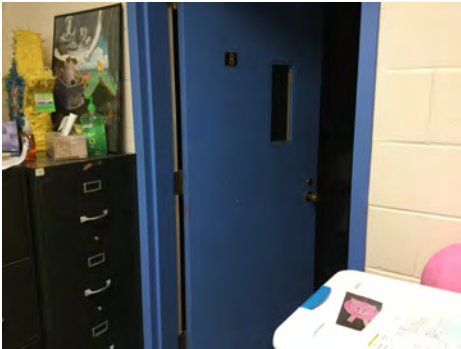
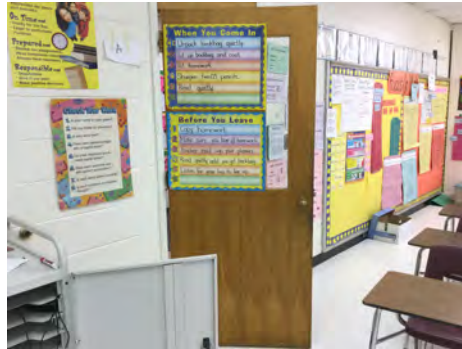
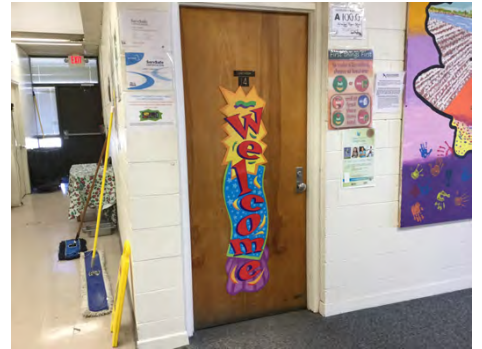
System: C1020 - Interior Doors

Note: The interior doors are beyond their service life and should be replaced, and when the doors are replaced the hardware installed should be ADA compliant.

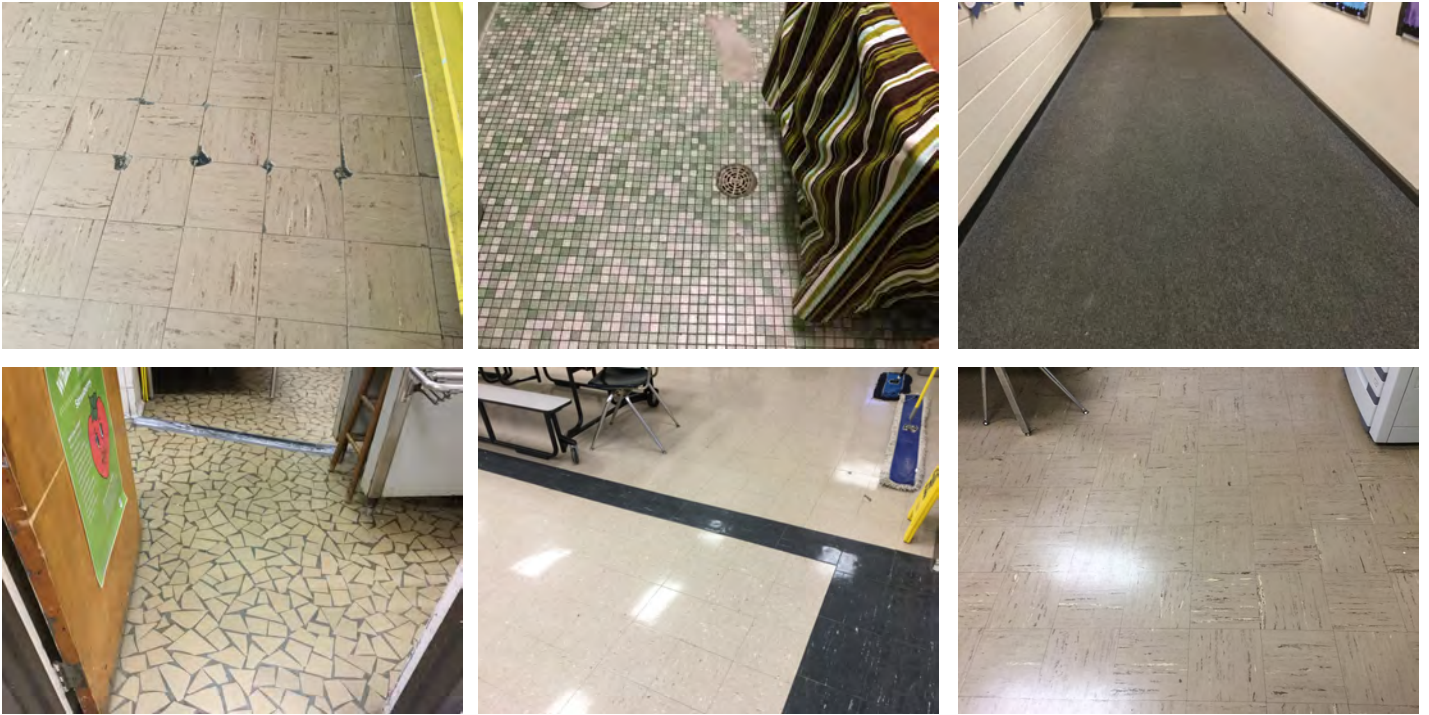
System: C3020 - Floor Finishes

Note: The flooring system is beyond its service life and should be replaced, the vinyl tiles contains suspected materials.

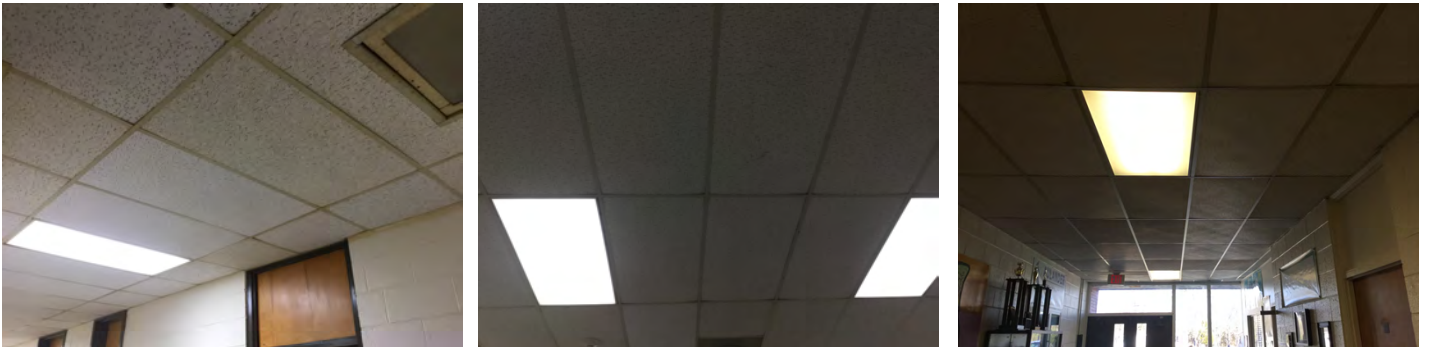
System: C3030 - Ceiling Finishes

Note: The ceiling tiles are beyond their service life and should be replaced.

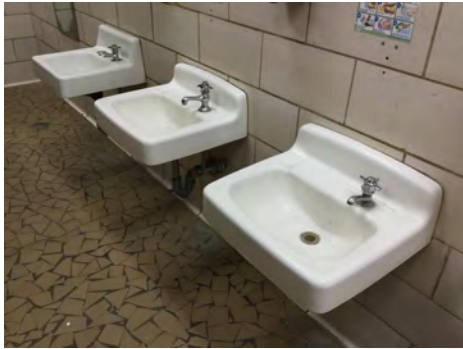
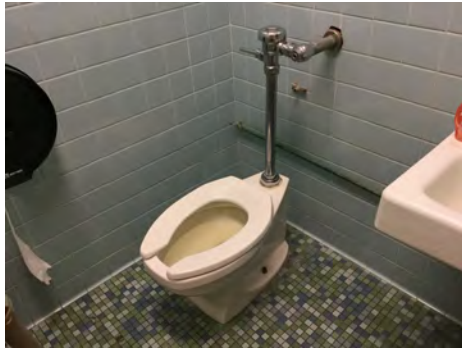
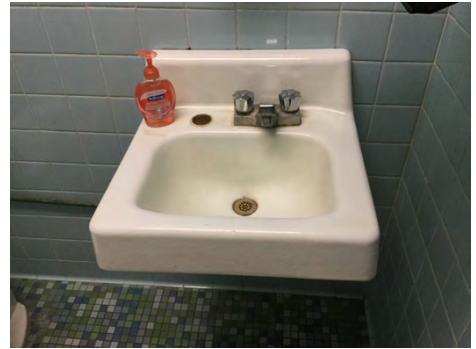
System: D2010 - Plumbing Fixtures

Note: The plumbing fixtures are beyond their service life and should be replaced.

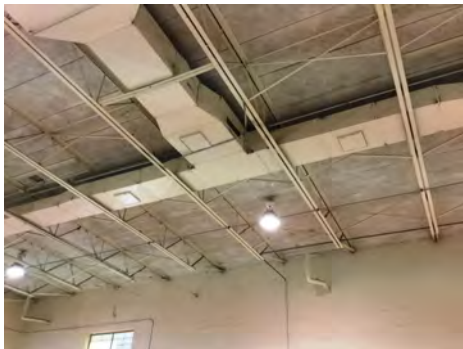
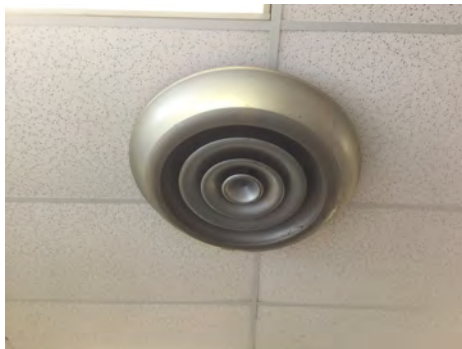
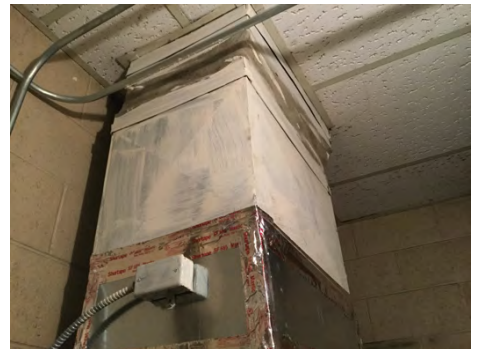
System: D3040 - Distribution Systems

Note: The distribution system is beyond its service life and should be replaced.

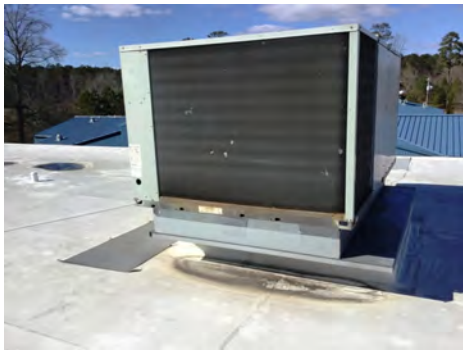
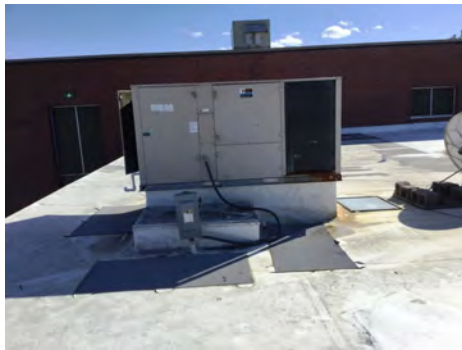
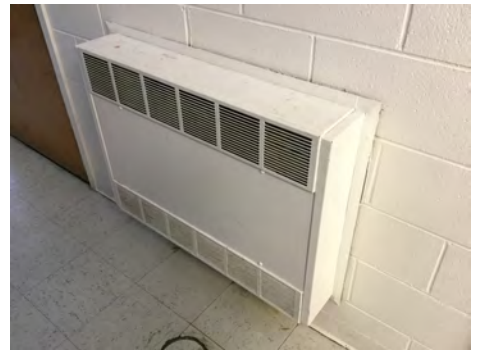
System: D3050 - Terminal & Package Units

Note: The terminal and package units are beyond their service life and should be replaced.

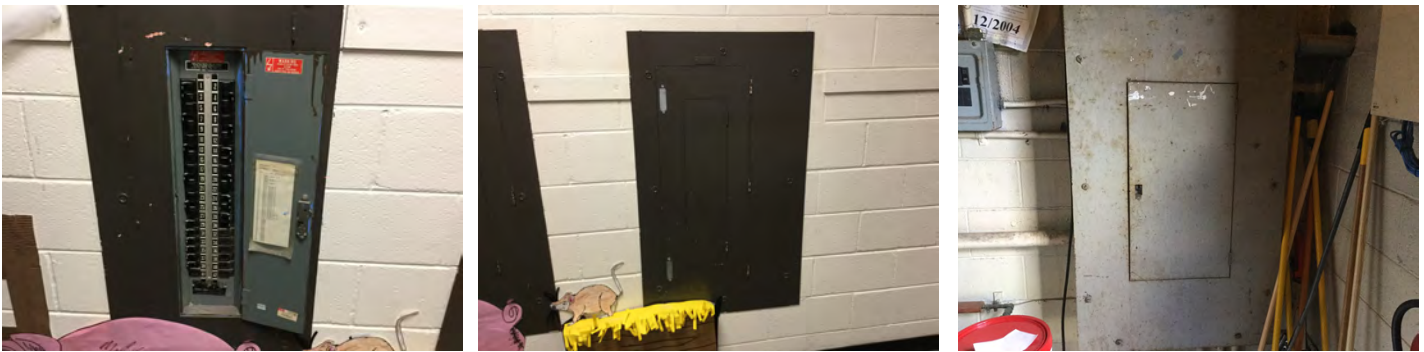
System: D5020 - Branch Wiring

Note: The branch wiring is beyond its service life and should be replaced.

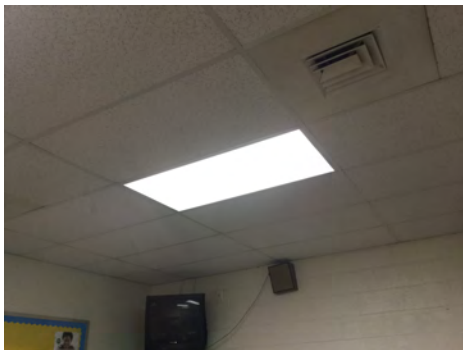
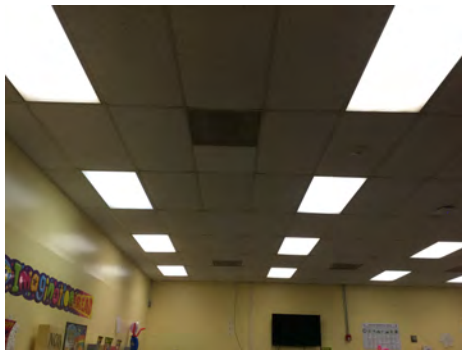
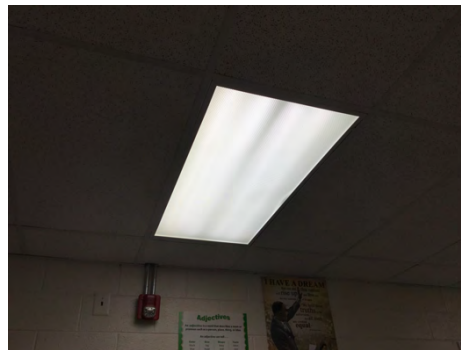
System: D5020 - Lighting

Note: The lighting system is beyond its service life and should be replaced.
