NC School District/080 Bertie County/Middle School

Bertie Middle

Campus Assessment Report

March 8, 2017

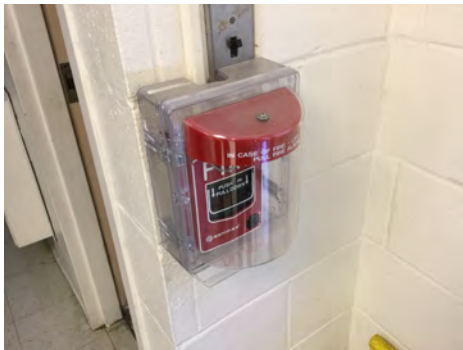
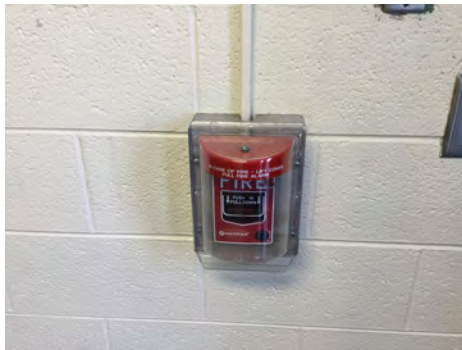
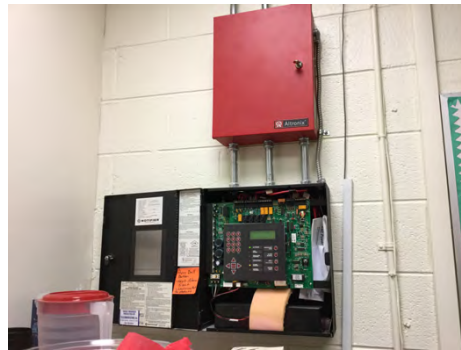
System: D5030910 - Fire Alarm Systems

Note: The fire alarm system is beyond its service life and should be replaced.

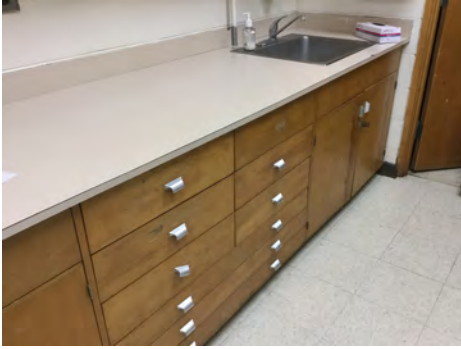
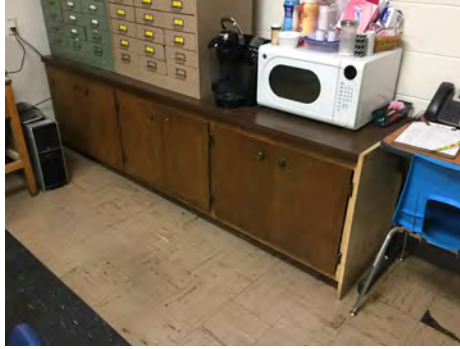
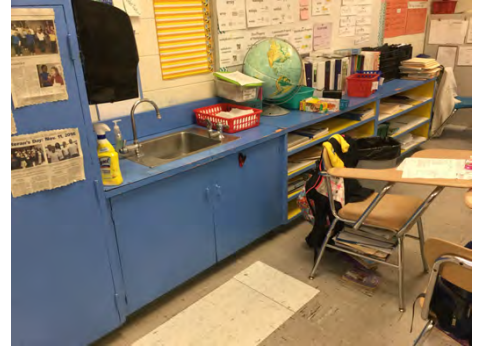
System: E2010 - Fixed Furnishings

Note: The fixed furnishings are beyond their service life and should be replaced.

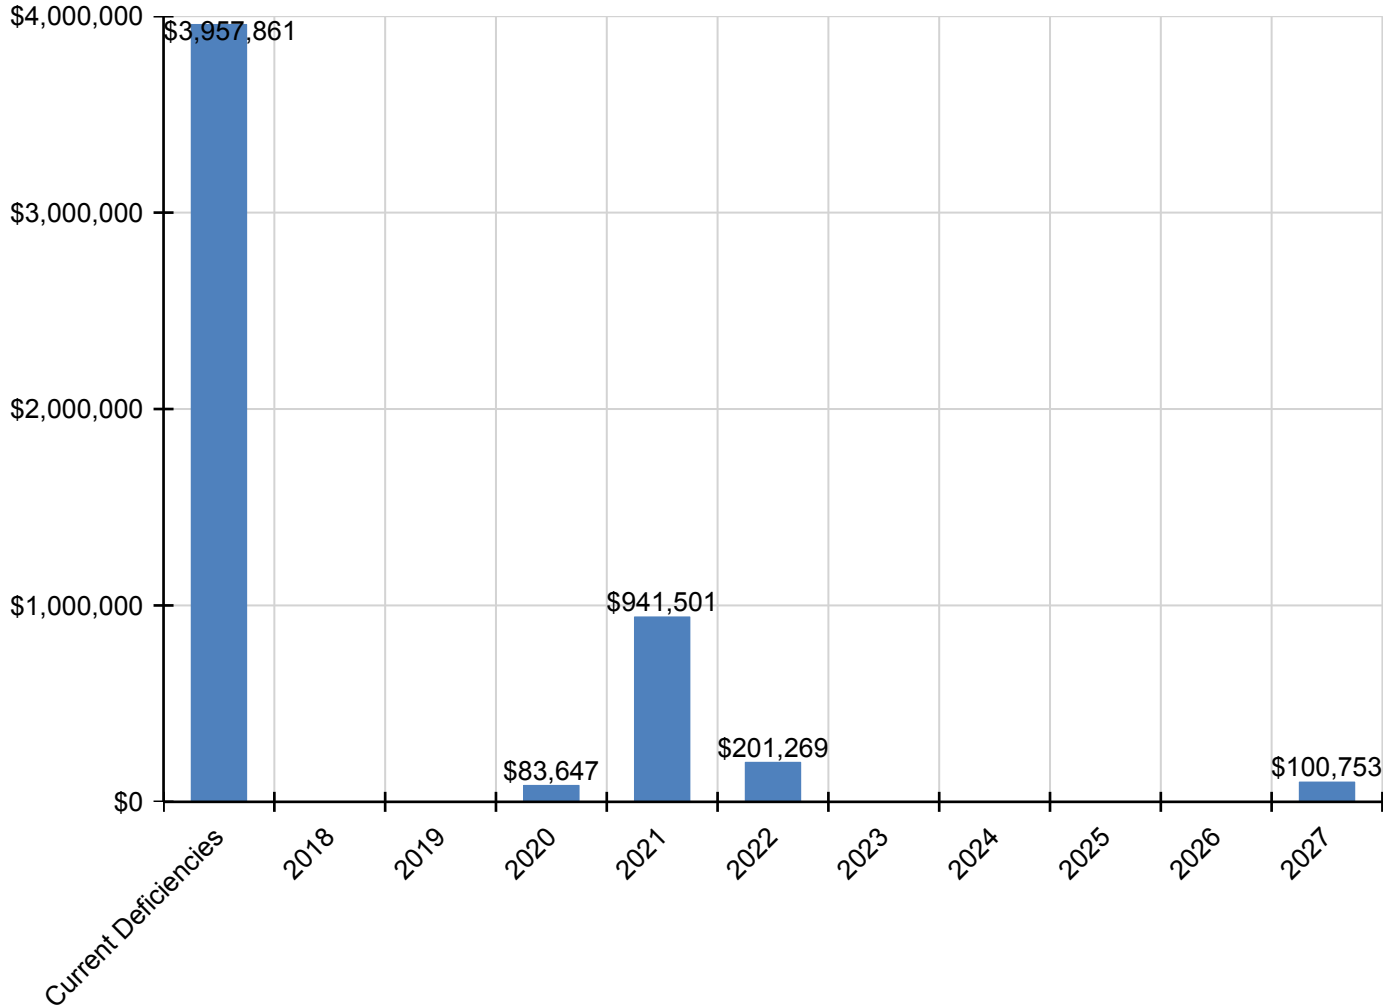
Forecasted Capital Renewal Requirement

The following chart shows the current building deficiencies and forecasting capital renewal or sustainment requirements over the next ten years.

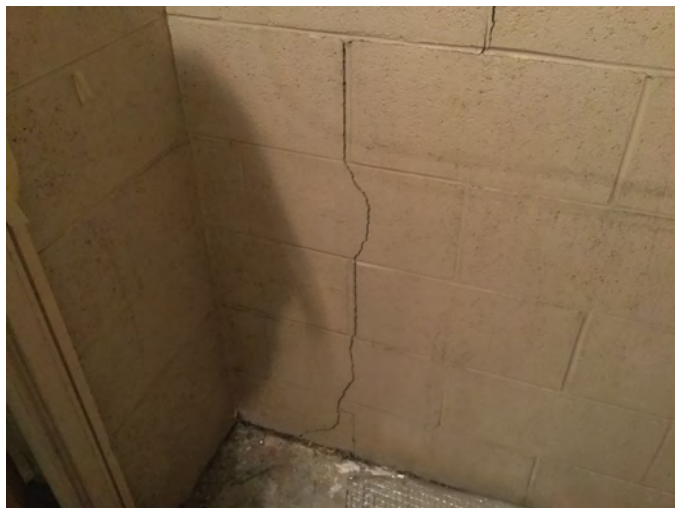
System: C1010 - Partitions

Location: Room 13
Distress: Failing
Category: Life Safety Code Compliance
Priority: 1 - Currently Critical (Immediate)
Correction: Engineering Study
Qty: 1.00
Unit of Measure: Ea.
Estimate: \$13,200.00
Assessor Name: Eduardo Lopez
Date Created: 01/31/2017

Notes: There are visible cracks on the partition wall which should be studied by a professional engineer.

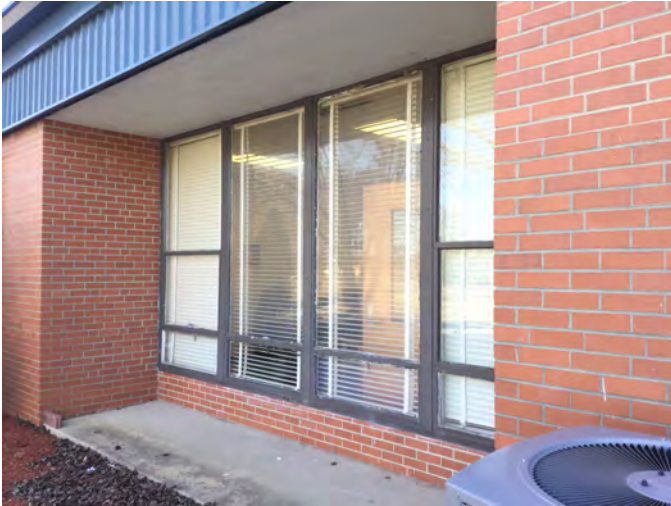
System: B2020 - Exterior Windows

Location: Exterior Walls
Distress: Beyond Service Life
Category: Deferred Maintenance
Priority: 3 - Necessary/Not Yet Critical (Years 2-5)
Correction: Renew System
Qty: 35,871.00
Unit of Measure: S.F.
Estimate: \$370,512.00
Assessor Name: Eduardo Lopez
Date Created: 02/06/2017

Notes: The exterior windows are beyond their service life and should be replaced.

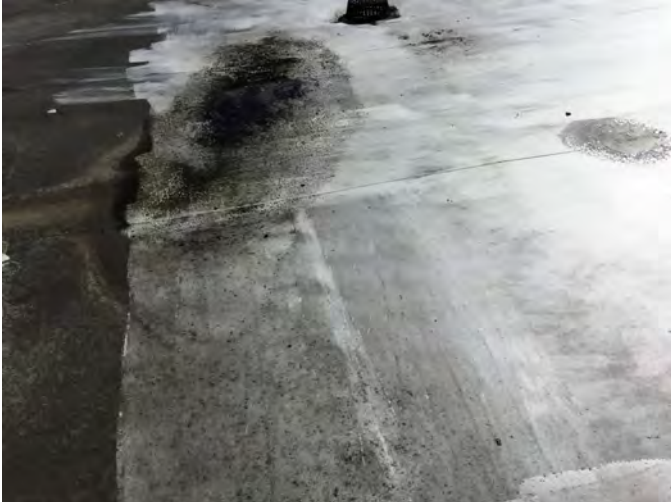
System: B3010120 - Single Ply Membrane

Location: Roof
Distress: Beyond Service Life
Category: Deferred Maintenance
Priority: 3 - Necessary/Not Yet Critical (Years 2-5)
Correction: Renew System
Qty: 4,965.00
Unit of Measure: S.F.
Estimate: \$51,984.00
Assessor Name: Eduardo Lopez
Date Created: 02/06/2017

Notes: The roof covering is in poor condition and should be replaced.

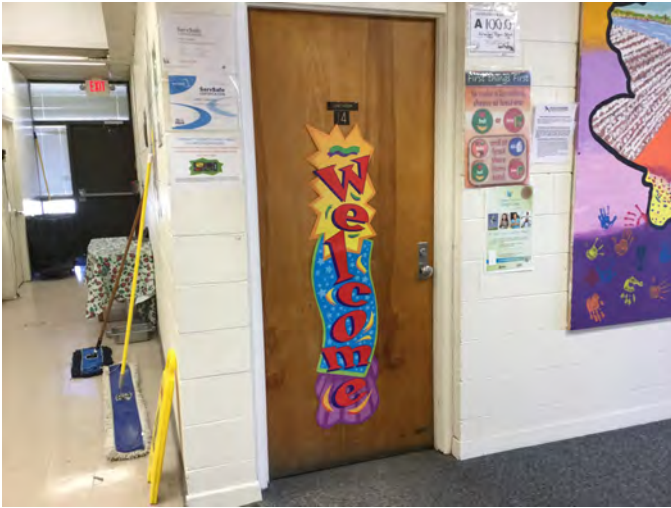
System: C1020 - Interior Doors

Location: Throughout Building
Distress: Beyond Service Life
Category: Deferred Maintenance
Priority: 3 - Necessary/Not Yet Critical (Years 2-5)
Correction: Renew System
Qty: 35,871.00
Unit of Measure: S.F.
Estimate: \$99,829.00
Assessor Name: Eduardo Lopez
Date Created: 02/06/2017

Notes: The interior doors are beyond their service life and should be replaced, and when the doors are replaced the hardware installed should be ADA compliant.

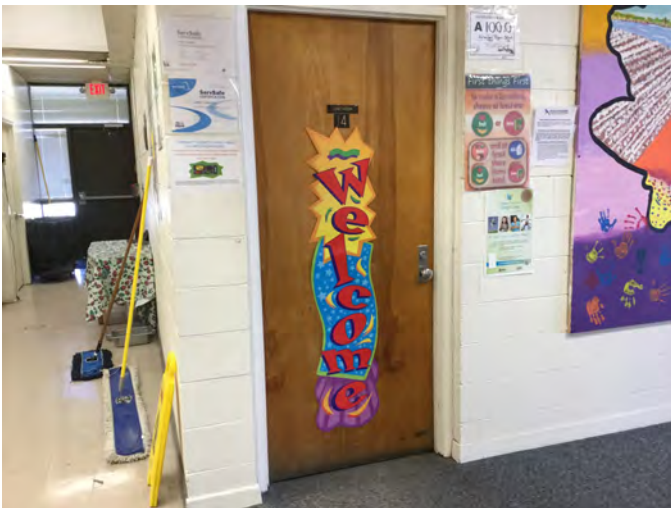
System: C1030 - Fittings

Location: Throughout the building
Distress: Inadequate
Category: Accessibility Code Compliance
Priority: 3 - Necessary/Not Yet Critical (Years 2-5)
Correction: Replace signage and toilet partitions
Qty: 50.00
Unit of Measure: Ea.
Estimate: \$5,299.47
Assessor Name: Eduardo Lopez
Date Created: 01/31/2017

Notes: The signages throughout the building are not ADA compliant and should be replaced.

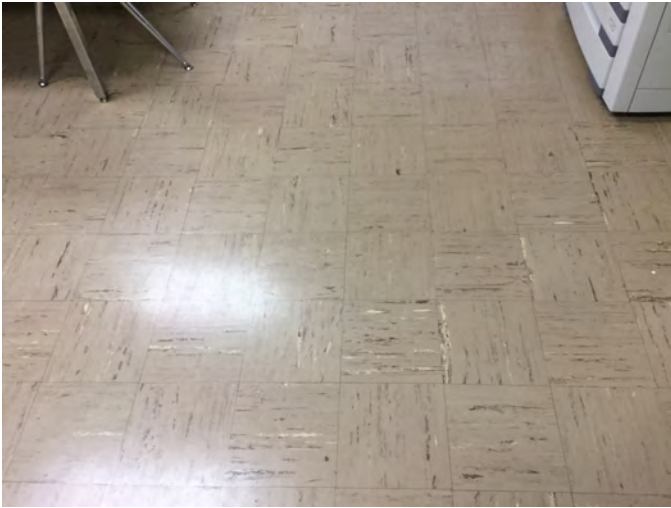
System: C3020 - Floor Finishes

Location: Throughout Building
Distress: Beyond Service Life
Category: Deferred Maintenance
Priority: 3 - Necessary/Not Yet Critical (Years 2-5)
Correction: Renew System
Qty: 35,871.00
Unit of Measure: S.F.
Estimate: \$530,676.00
Assessor Name: Eduardo Lopez
Date Created: 02/06/2017

Notes: The flooring system is beyond its service life and should be replaced, the vinyl tiles contains suspected materials.

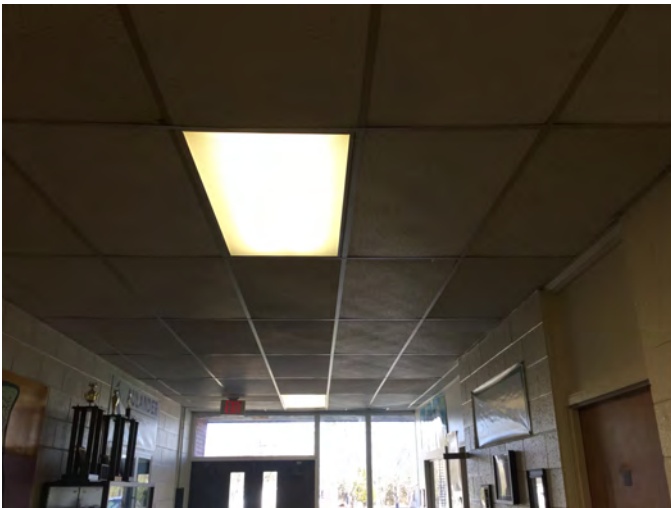
System: C3030 - Ceiling Finishes

Location: Throughout Building
Distress: Beyond Service Life
Category: Deferred Maintenance
Priority: 3 - Necessary/Not Yet Critical (Years 2-5)
Correction: Renew System
Qty: 35,871.00
Unit of Measure: S.F.
Estimate: \$432,855.00
Assessor Name: Eduardo Lopez
Date Created: 02/06/2017

Notes: The ceiling tiles are beyond their service life and should be replaced.

Note: The ceiling tiles are beyond their service life and should be replaced.

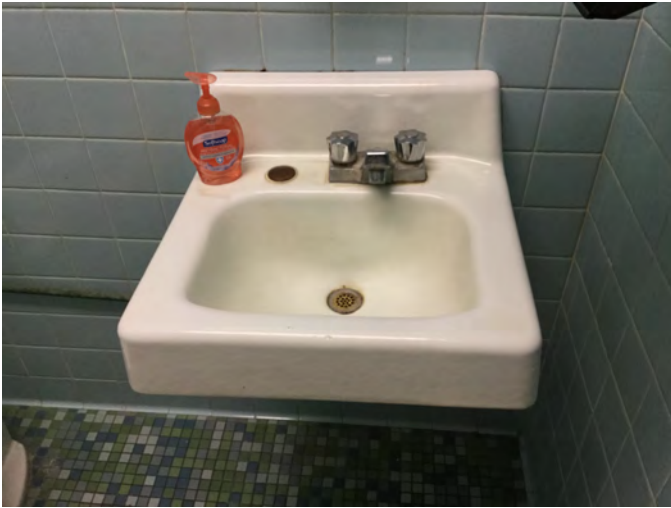
System: D2010 - Plumbing Fixtures

Location: Throughout Building
Distress: Beyond Service Life
Category: Deferred Maintenance
Priority: 3 - Necessary/Not Yet Critical (Years 2-5)
Correction: Renew System
Qty: 35,871.00
Unit of Measure: S.F.
Estimate: \$452,979.00
Assessor Name: Eduardo Lopez
Date Created: 02/06/2017

Notes: The plumbing fixtures are beyond their service life and should be replaced.

Note: The plumbing fixtures are beyond their service life and should be replaced.

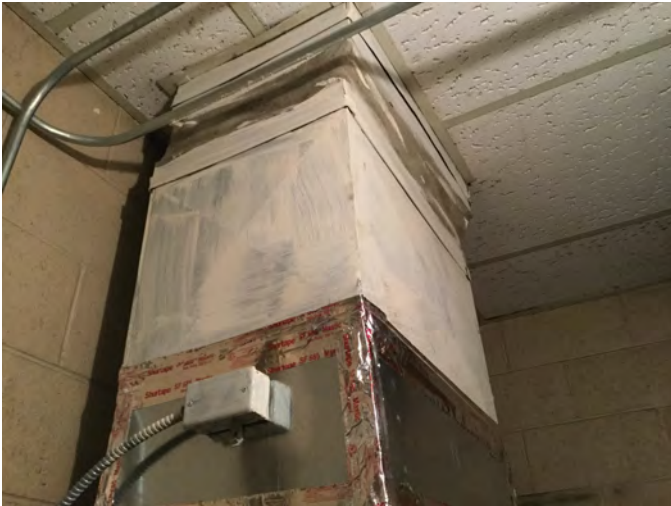
System: D3040 - Distribution Systems

Location: Throughout Building
Distress: Beyond Service Life
Category: Deferred Maintenance
Priority: 3 - Necessary/Not Yet Critical (Years 2-5)
Correction: Renew System
Qty: 35,871.00
Unit of Measure: S.F.
Estimate: \$242,273.00
Assessor Name: Eduardo Lopez
Date Created: 02/06/2017

Notes: The distribution system is beyond its service life and should be replaced.

Note: The distribution system is beyond its service life and should be replaced.

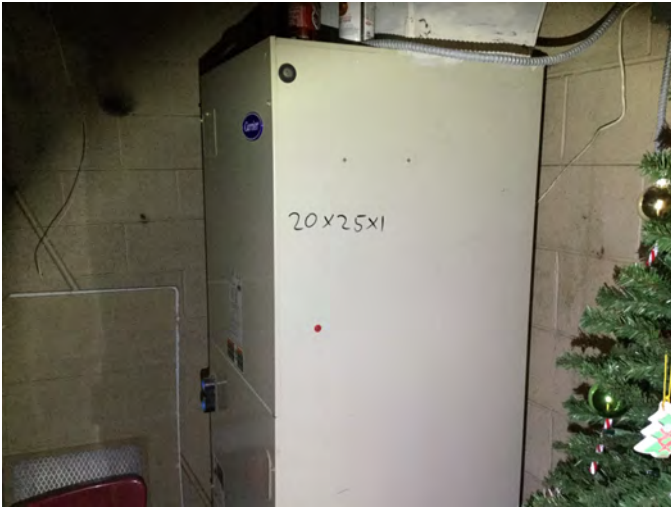
System: D3050 - Terminal & Package Units

Location: Throughout Building
Distress: Beyond Service Life
Category: Deferred Maintenance
Priority: 3 - Necessary/Not Yet Critical (Years 2-5)
Correction: Renew System
Qty: 35,871.00
Unit of Measure: S.F.
Estimate: \$527,555.00
Assessor Name: Eduardo Lopez
Date Created: 02/06/2017

Notes: The terminal and package units are beyond their service life and should be replaced.

Note: The terminal and package units are beyond their service life and should be replaced.

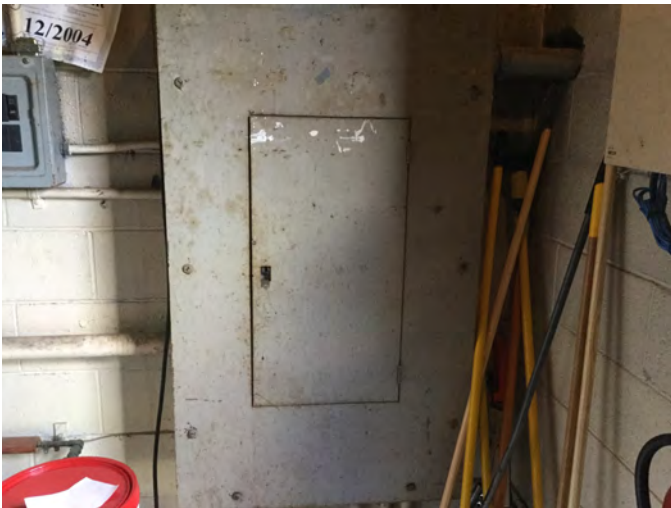
System: D5020 - Branch Wiring

Location: Throughout Building
Distress: Beyond Service Life
Category: Deferred Maintenance
Priority: 3 - Necessary/Not Yet Critical (Years 2-5)
Correction: Renew System
Qty: 35,871.00
Unit of Measure: S.F.
Estimate: \$199,658.00
Assessor Name: Eduardo Lopez
Date Created: 02/06/2017

Notes: The branch wiring is beyond its service life and should be replaced.

Note: The branch wiring is beyond its service life and should be replaced.

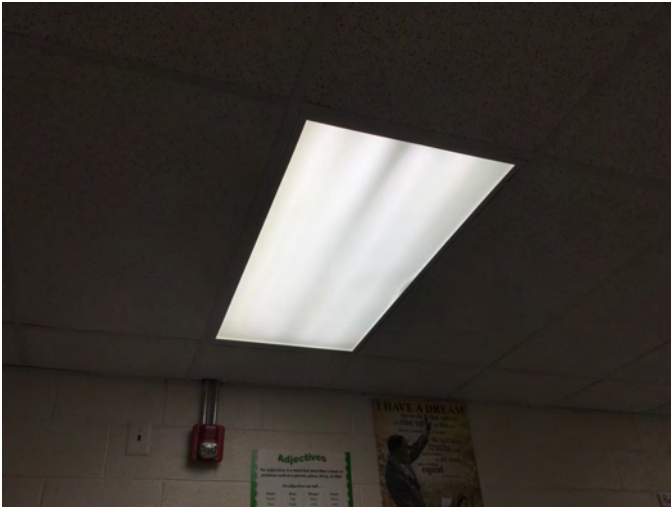
System: D5020 - Lighting

Location: Throughout Building
Distress: Beyond Service Life
Category: Deferred Maintenance
Priority: 3 - Necessary/Not Yet Critical (Years 2-5)
Correction: Renew System
Qty: 35,871.00
Unit of Measure: S.F.
Estimate: \$470,341.00
Assessor Name: Eduardo Lopez
Date Created: 02/06/2017

Notes: The lighting system is beyond its service life and should be replaced.

Note: The lighting system is beyond its service life and should be replaced.

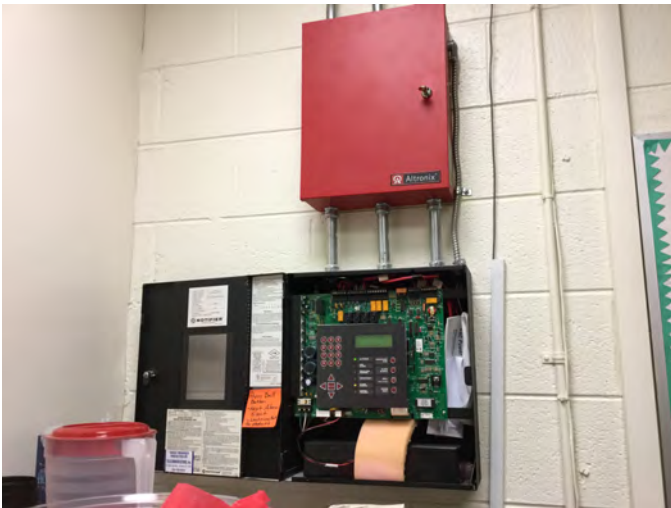
System: D5030910 - Fire Alarm Systems

Location: Throughout Building
Distress: Beyond Service Life
Category: Deferred Maintenance
Priority: 3 - Necessary/Not Yet Critical (Years 2-5)
Correction: Renew System
Qty: 35,871.00
Unit of Measure: S.F.
Estimate: \$133,763.00
Assessor Name: Eduardo Lopez
Date Created: 02/06/2017

Notes: The fire alarm system is beyond its service life and should be replaced.

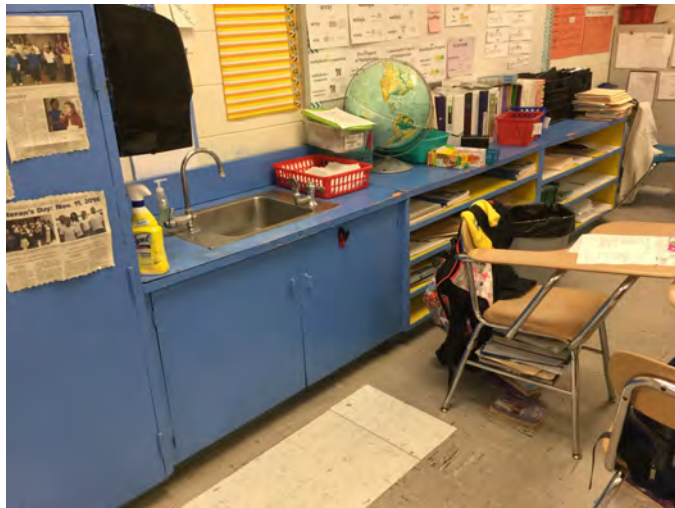
System: E2010 - Fixed Furnishings

Location: Throughout Building
Distress: Beyond Service Life
Category: Deferred Maintenance
Priority: 3 - Necessary/Not Yet Critical (Years 2-5)
Correction: Renew System
Qty: 35,871.00
Unit of Measure: S.F.
Estimate: \$230,041.00
Assessor Name: Eduardo Lopez
Date Created: 02/06/2017

Notes: The fixed furnishings are beyond their service life and should be replaced.

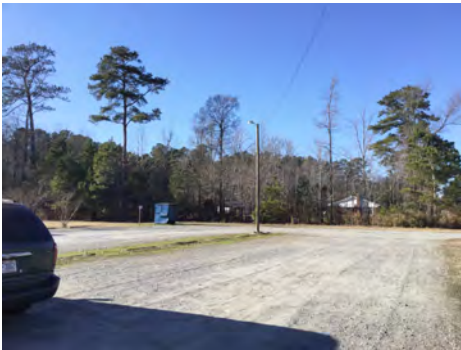
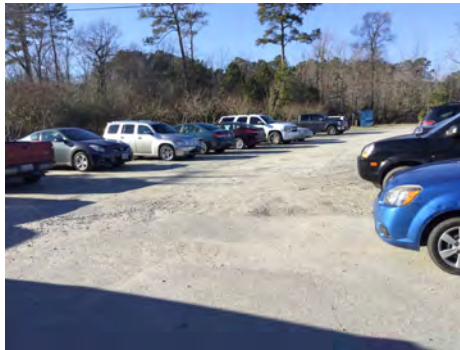
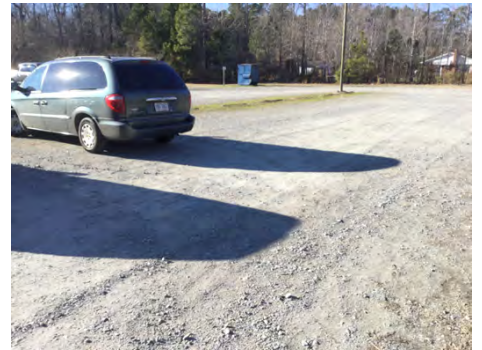
System: G2020 - Parking Lots

Note: The parking area is in poor condition and should be replaced.

Location: Site
Distress: Inadequate
Category: Accessibility Code Compliance
Priority: 3 - Necessary/Not Yet Critical (Years 2-5)
Correction: Renew System
Qty: 35,871.00
Unit of Measure: S.F.
Estimate: \$52,479.00
Assessor Name: Eduardo Lopez
Date Created: 01/31/2017

Notes: The parking area is in poor condition and should be replaced.

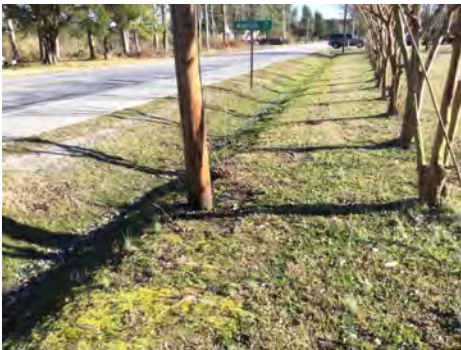
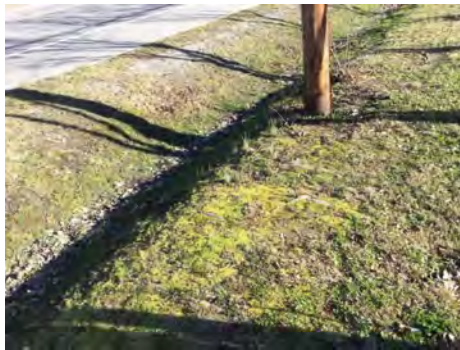
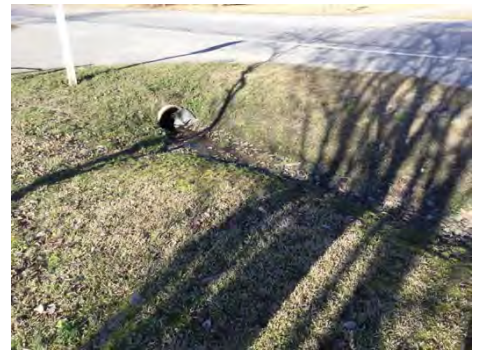
System: G3030 - Storm Sewer

Note: The storm sewer system is an open drainage system, and proper piping should be installed.

Notes: The storm sewer system is an open drainage system, and proper piping should be installed.

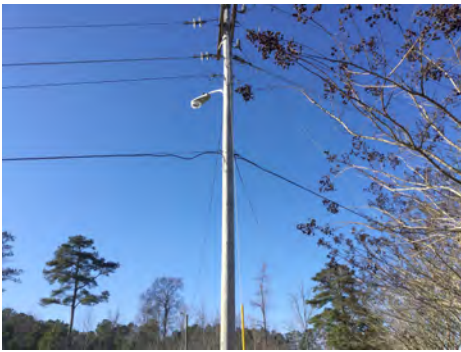
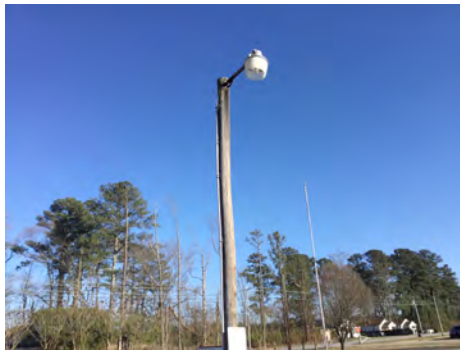
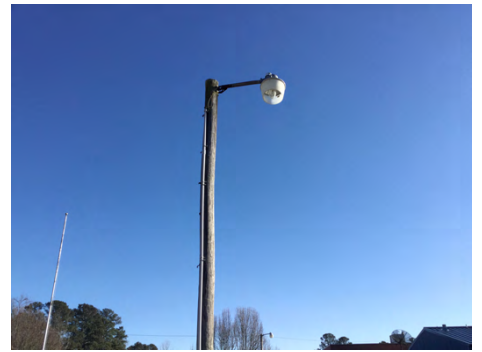
System: G4020 - Site Lighting

Note: The lighting system is inadequate and beyond its service life and should be replaced.

Notes: The lighting system is inadequate and beyond its service life and should be replaced.

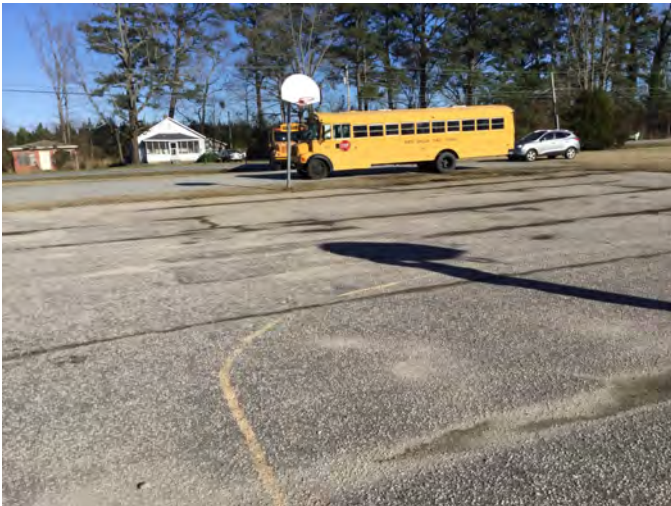
System: G2040950 - Hard Surface Play Area

Location: Site
Distress: Failing
Category: Deferred Maintenance
Priority: 3 - Necessary/Not Yet Critical (Years 2-5)
Correction: Resurface hard surface
Qty: 3,300.00
Unit of Measure: S.F.
Estimate: \$26,136.00
Assessor Name: Eduardo Lopez
Date Created: 01/31/2017

Notes: The hard surface play area needs to be resurfaced.

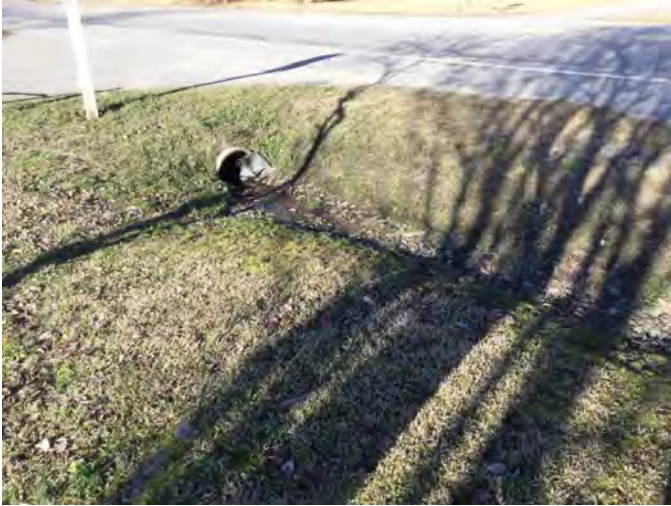
System: G3030 - Storm Sewer

Location: Site
Distress: Beyond Service Life
Category: Deferred Maintenance
Priority: 3 - Necessary/Not Yet Critical (Years 2-5)
Correction: Renew System
Qty: 35,871.00
Unit of Measure: S.F.
Estimate: \$179,140.00
Assessor Name: Eduardo Lopez
Date Created: 02/06/2017

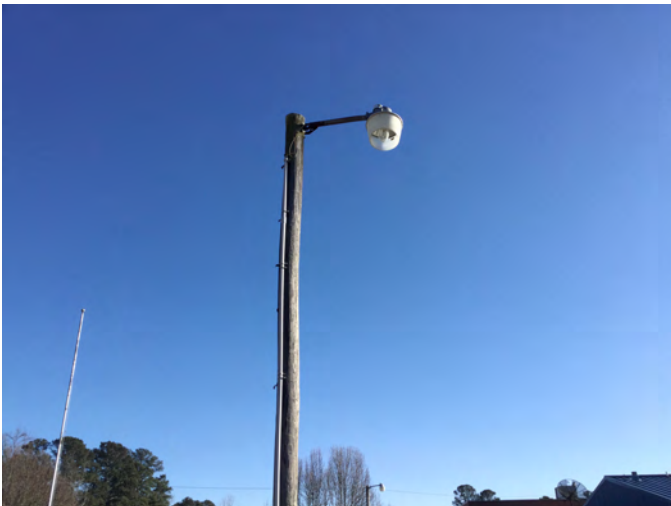
System: G4020 - Site Lighting

Location: Site
Distress: Beyond Service Life
Category: Deferred Maintenance
Priority: 3 - Necessary/Not Yet Critical (Years 2-5)
Correction: Renew System
Qty: 35,871.00
Unit of Measure: S.F.
Estimate: \$58,003.00
Assessor Name: Eduardo Lopez
Date Created: 01/31/2017

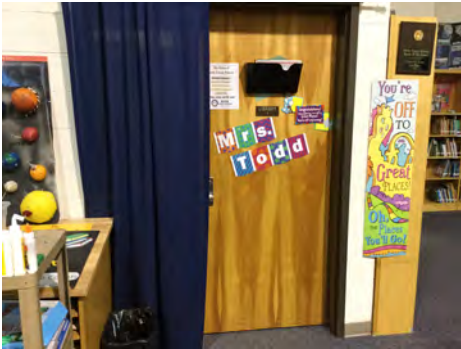
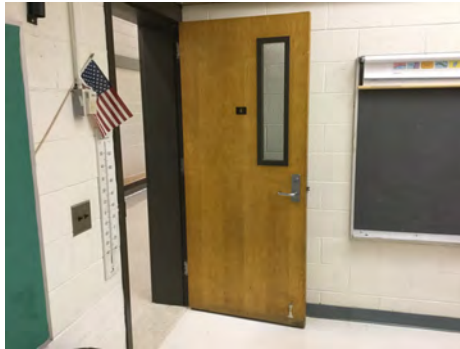
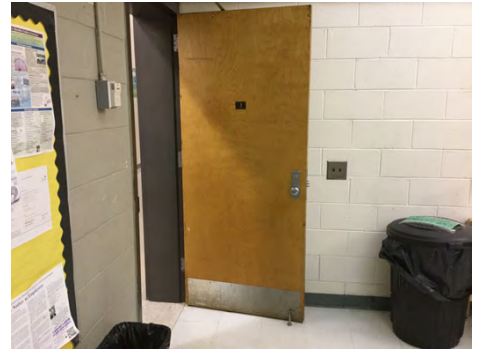
System: C1020 - Interior Doors

Note: The interior doors are beyond their service life and should be replaced, and during the replacement ADA compliant hardware should be installed.

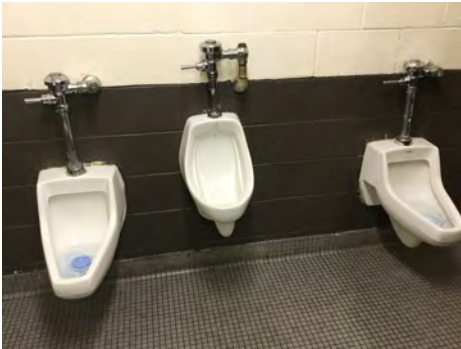
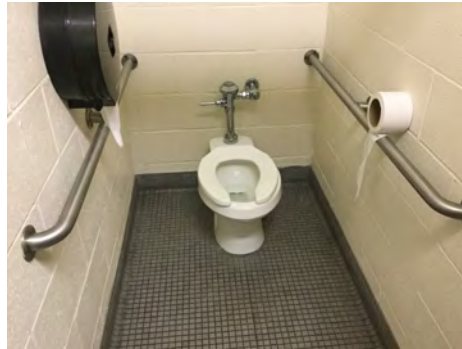
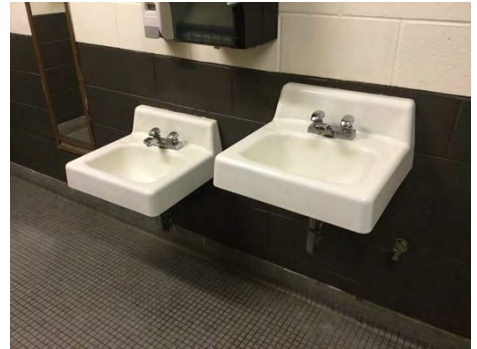
System: D2010 - Plumbing Fixtures

Note: The plumbing fixtures are beyond their service life and should be replaced.

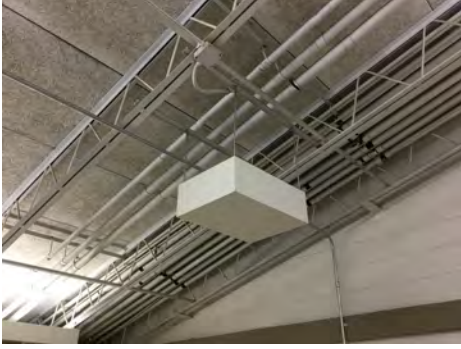
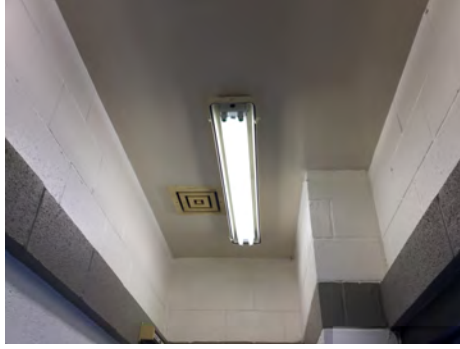
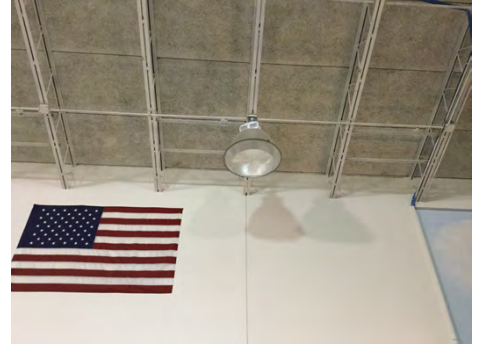
System: D5020 - Lighting

Note: The lighting system is beyond its service life and should be replaced with energy efficient lighting system.

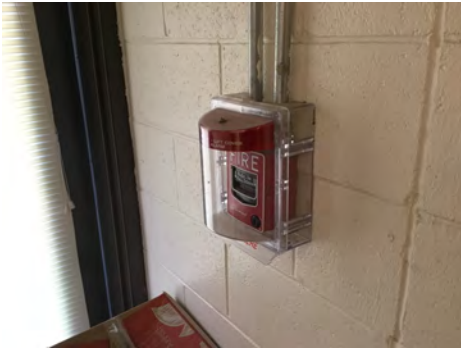
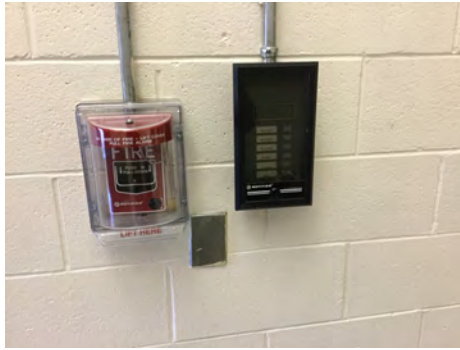
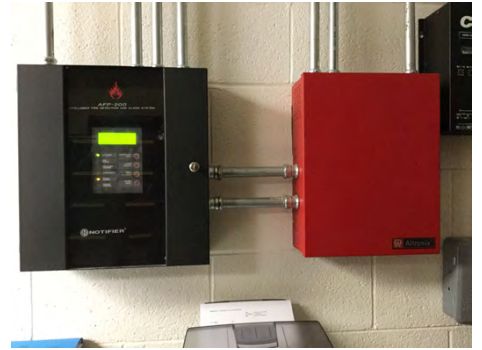
System: D5030910 - Fire Alarm Systems

Note: The fire alarm system is beyond its service life and should be replaced.

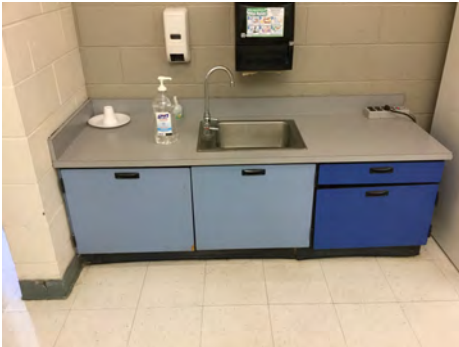
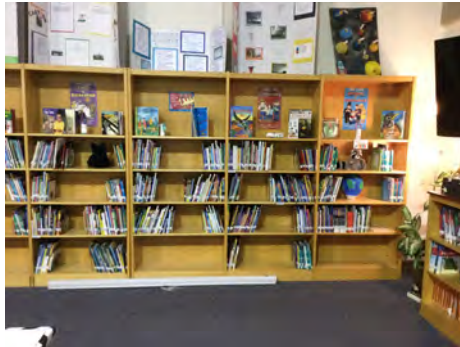
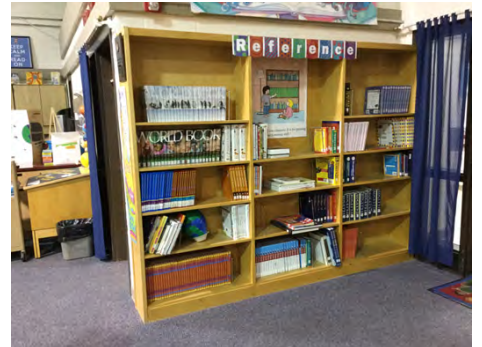
System: E2010 - Fixed Furnishings

Note: The fixed furnishings are beyond their service life and should be replaced.

Notes: The fixed furnishings are beyond their service life and should be replaced.

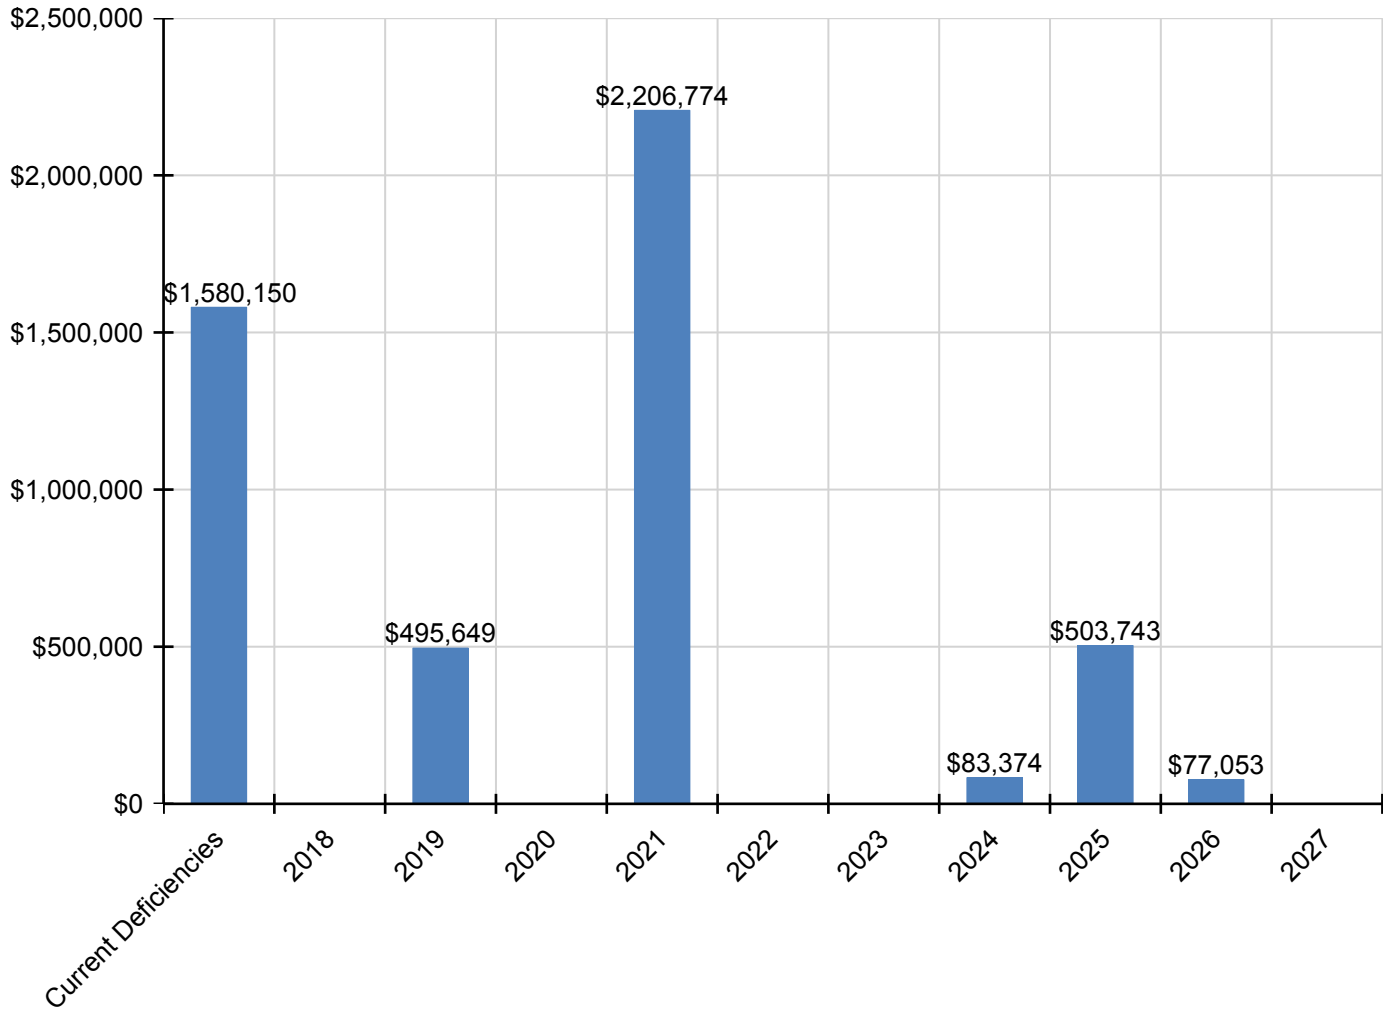
Forecasted Capital Renewal Requirement

The following chart shows the current building deficiencies and forecasting capital renewal or sustainment requirements over the next ten years.

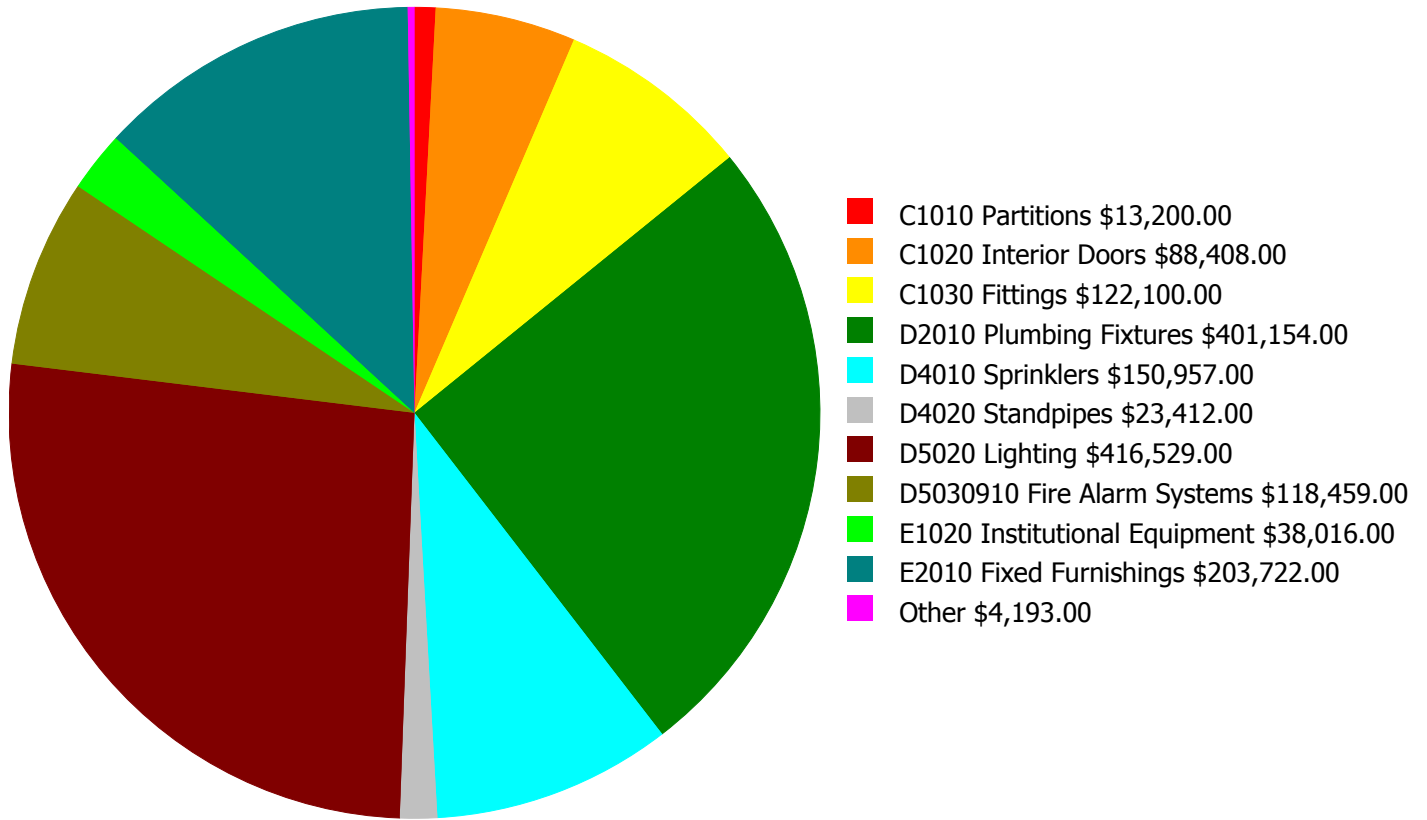
Deficiency Summary by System

Current deficiencies included assemblies that have reached or exceeded their design life or components of the assemblies that are in need of repair. Assemblies that have reached their design life are identified as current deficiencies and assigned the distress 'Beyond Useful Life'. The following chart lists all current deficiencies associated with this facility.

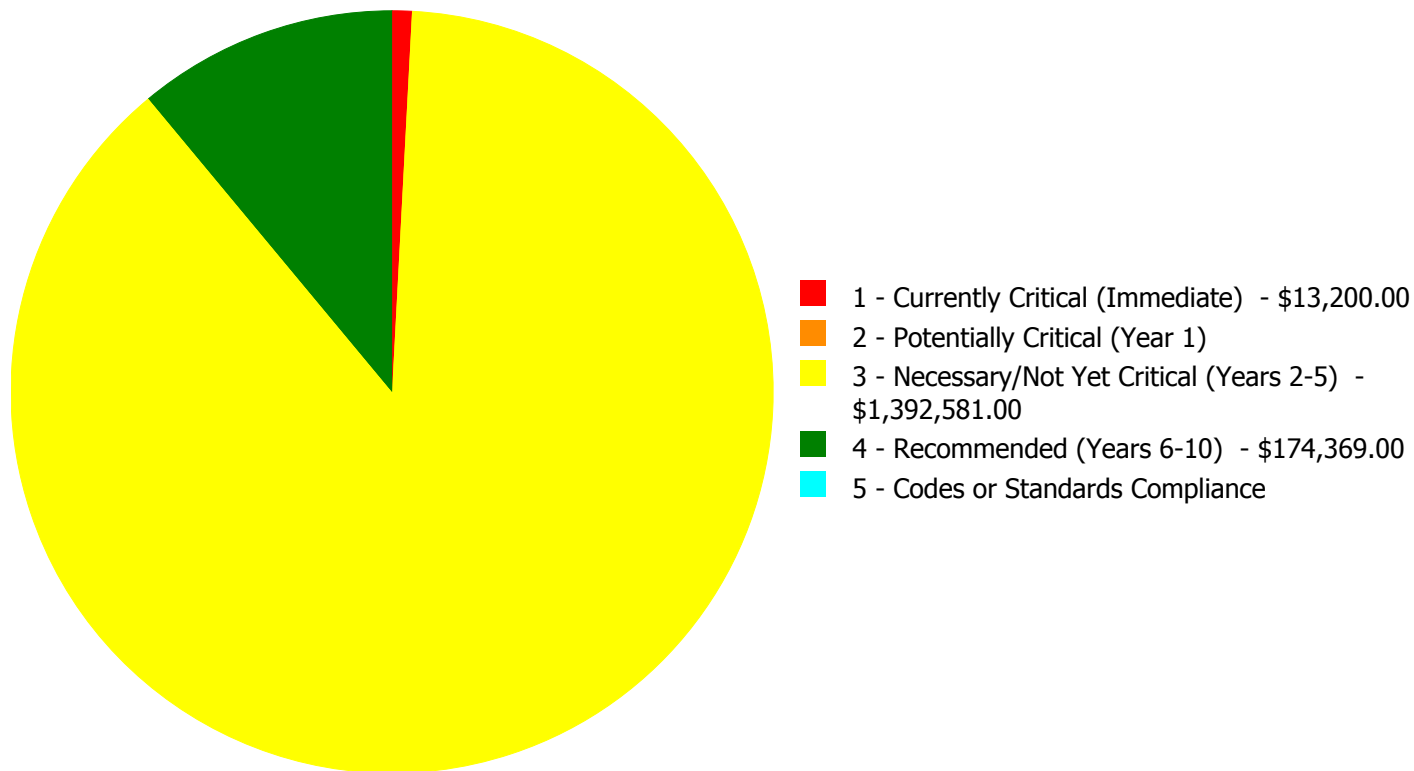
Deficiency Summary by Priority

The following chart shows the total repair costs broken down by priority. Assessors assigned deficiencies within eCOMET to one of the following priority categories:

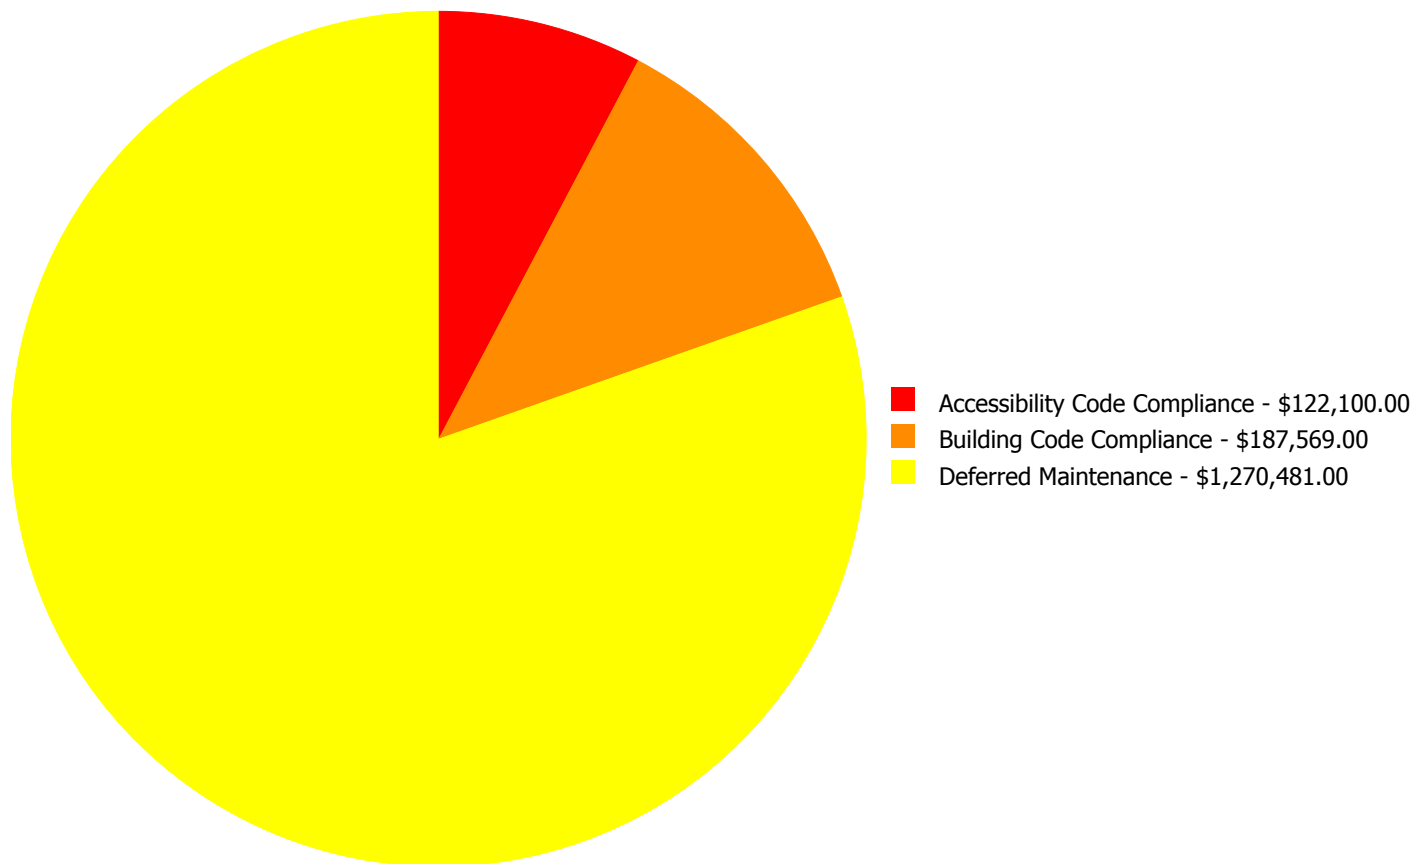
Deficiency Summary by Category

The following chart shows the total repair costs broken down by deficiency categories. Assessors assigned deficiencies to one of the following categories:

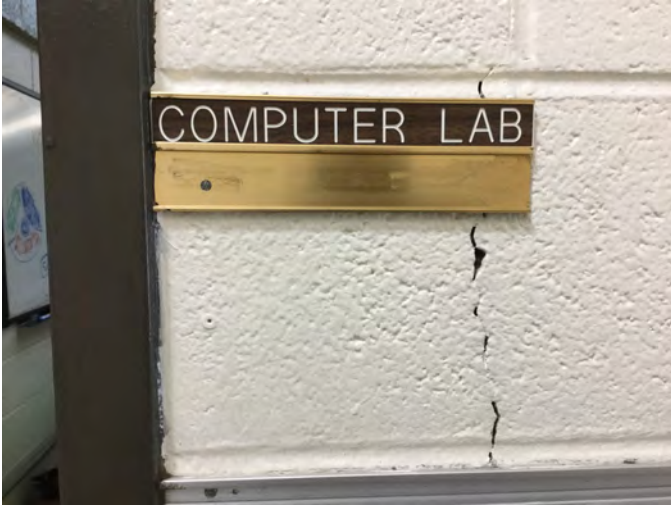
System: C1010 - Partitions

Location: Hallways
Distress: Failing
Category: Building Code Compliance
Priority: 1 - Currently Critical (Immediate)
Correction: Engineering Study
Qty: 1.00
Unit of Measure: Ea.
Estimate: \$13,200.00
Assessor Name: Somnath Das
Date Created: 01/30/2017

Notes: The partition walls are showing visible cracks which should be studied by a professional engineer.

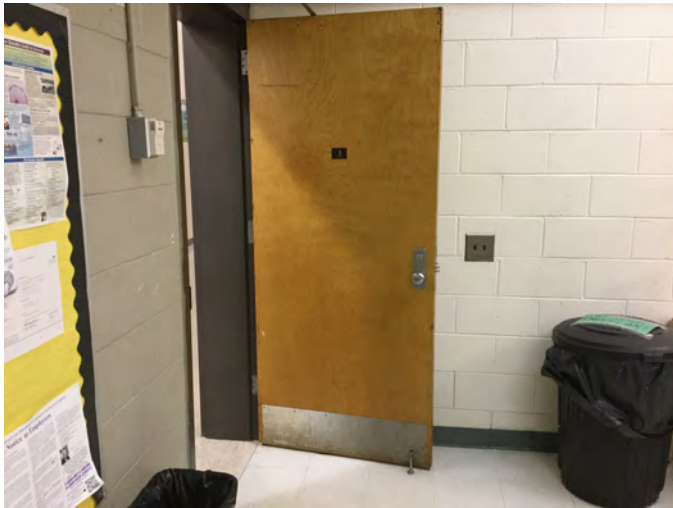
System: C1020 - Interior Doors

Location: Throughout Building
Distress: Beyond Service Life
Category: Deferred Maintenance
Priority: 3 - Necessary/Not Yet Critical (Years 2-5)
Correction: Renew System
Qty: 31,767.00
Unit of Measure: S.F.
Estimate: \$88,408.00
Assessor Name: Somnath Das
Date Created: 02/01/2017

Notes: The interior doors are beyond their service life and should be replaced, and during the replacement ADA compliant hardware should be installed.

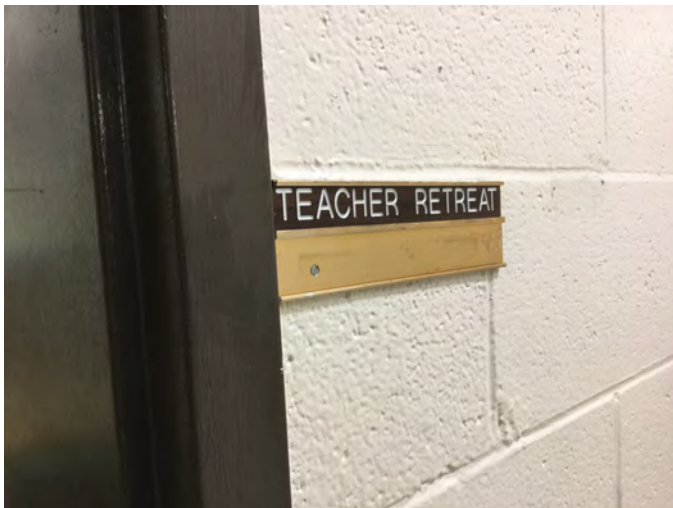
System: C1030 - Fittings

Location: Throughout the building
Distress: Beyond Service Life
Category: Accessibility Code Compliance
Priority: 3 - Necessary/Not Yet Critical (Years 2-5)
Correction: Replace signage and toilet partitions
Qty: 50.00
Unit of Measure: Ea.
Estimate: \$122,100.00
Assessor Name: Somnath Das
Date Created: 01/30/2017

Notes: The signages throughout the building are not ADA compliant and they should be replaced.

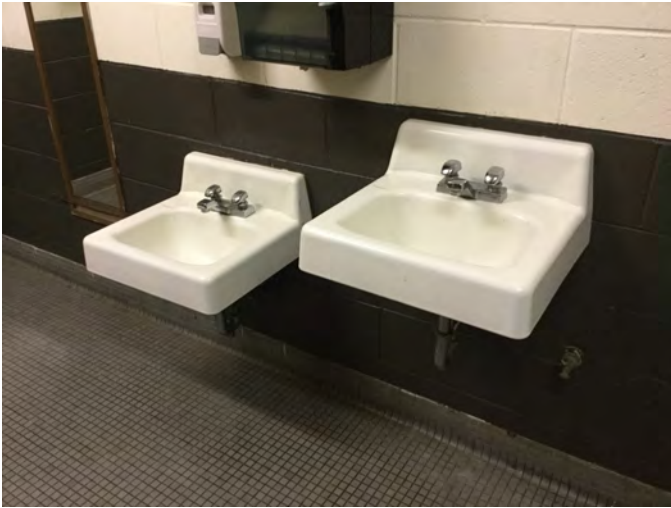
System: D2010 - Plumbing Fixtures

Location: Throughout Building
Distress: Beyond Service Life
Category: Deferred Maintenance
Priority: 3 - Necessary/Not Yet Critical (Years 2-5)
Correction: Renew System
Qty: 31,767.00
Unit of Measure: S.F.
Estimate: \$401,154.00
Assessor Name: Somnath Das
Date Created: 02/01/2017

Notes: The plumbing fixtures are beyond their service life and should be replaced.

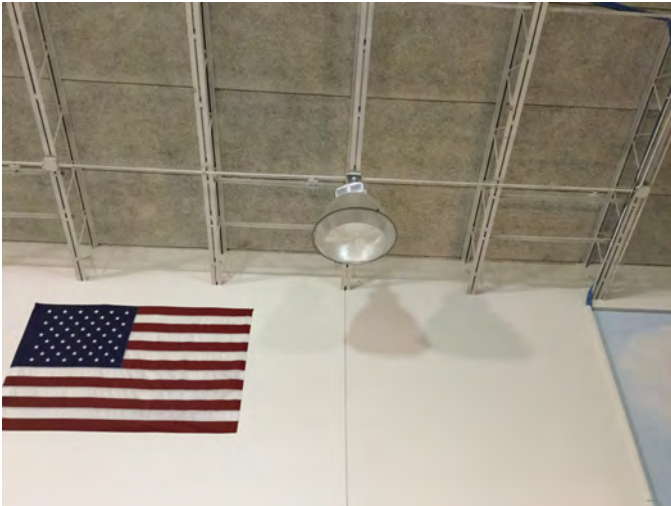
System: D5020 - Lighting

Location: Throughout Building
Distress: Beyond Service Life
Category: Deferred Maintenance
Priority: 3 - Necessary/Not Yet Critical (Years 2-5)
Correction: Renew System
Qty: 31,767.00
Unit of Measure: S.F.
Estimate: \$416,529.00
Assessor Name: Somnath Das
Date Created: 02/01/2017

Notes: The lighting system is beyond its service life and should be replaced with energy efficient lighting system.

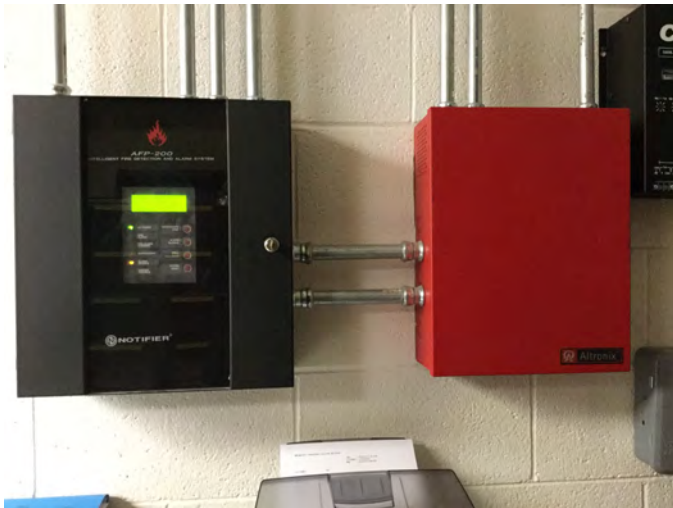
System: D5030910 - Fire Alarm Systems

Location: Throughout Building
Distress: Beyond Service Life
Category: Deferred Maintenance
Priority: 3 - Necessary/Not Yet Critical (Years 2-5)
Correction: Renew System
Qty: 31,767.00
Unit of Measure: S.F.
Estimate: \$118,459.00
Assessor Name: Somnath Das
Date Created: 02/01/2017

Notes: The fire alarm system is beyond its service life and should be replaced.

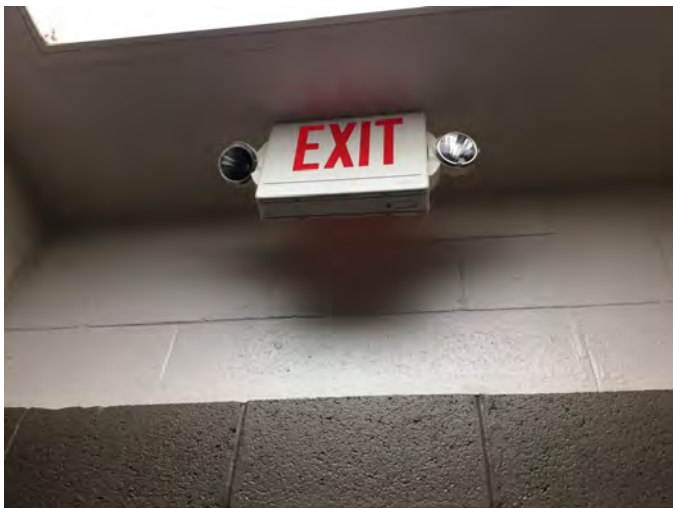
System: D5090 - Other Electrical Systems

Location: 1986 Main Building
Distress: Beyond Service Life
Category: Deferred Maintenance
Priority: 3 - Necessary/Not Yet Critical (Years 2-5)
Correction: Renew System
Qty: 31,767.00
Unit of Measure: S.F.
Estimate: \$4,193.00
Assessor Name: Somnath Das
Date Created: 02/24/2017
