NC School District/080 Bertie County/Middle School

Bertie Middle

Campus Assessment Report

March 8, 2017

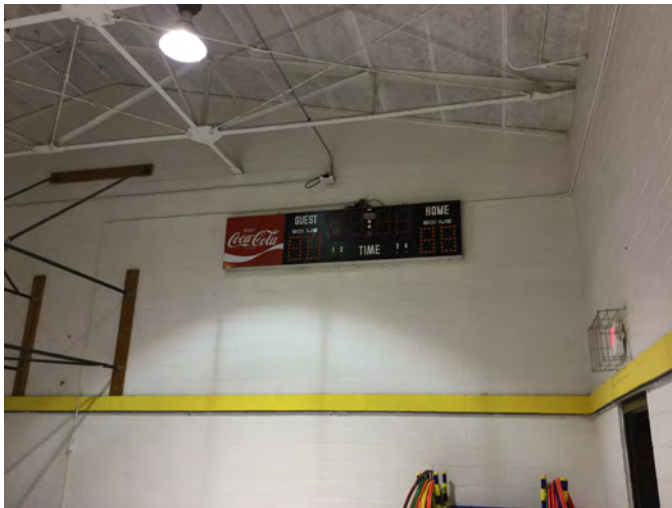
System: E1020 - Institutional Equipment

Location: Gymnasium
Distress: Beyond Service Life
Category: Deferred Maintenance
Priority: 3 - Necessary/Not Yet Critical (Years 2-5)
Correction: Replace athletic equipment
Qty: 2.00
Unit of Measure: Ea.
Estimate: \$38,016.00
Assessor Name: Somnath Das
Date Created: 01/30/2017

Notes: The athletic equipment is beyond its service life and should be replaced.

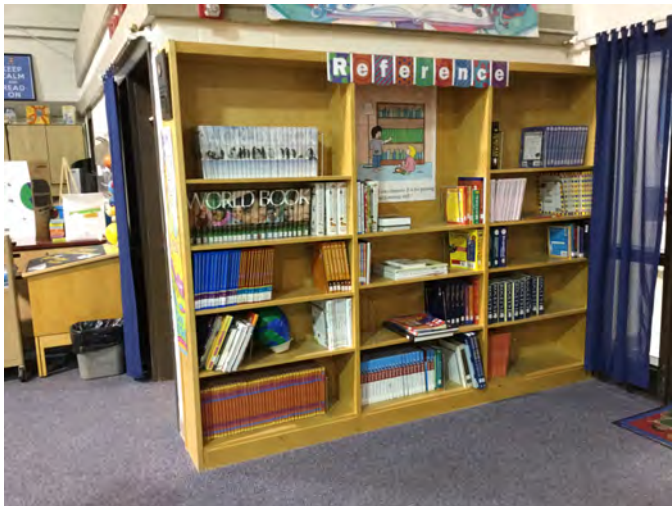
System: E2010 - Fixed Furnishings

Location: Throughout Building
Distress: Beyond Service Life
Category: Deferred Maintenance
Priority: 3 - Necessary/Not Yet Critical (Years 2-5)
Correction: Renew System
Qty: 31,767.00
Unit of Measure: S.F.
Estimate: \$203,722.00
Assessor Name: Somnath Das
Date Created: 02/01/2017

Notes: The fixed furnishings are beyond their service life and should be replaced.

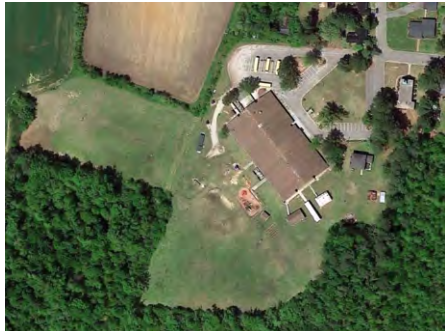
- 1). Aerial Image of Colerain Elementary School - Feb 09, 2017

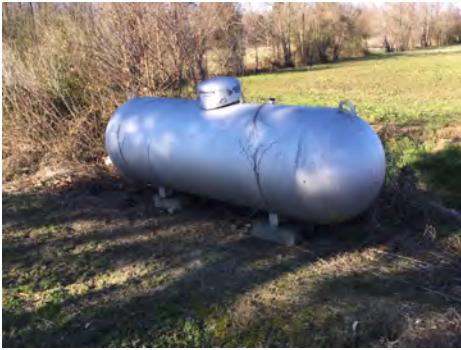
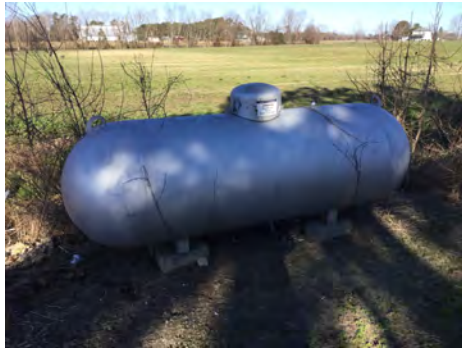
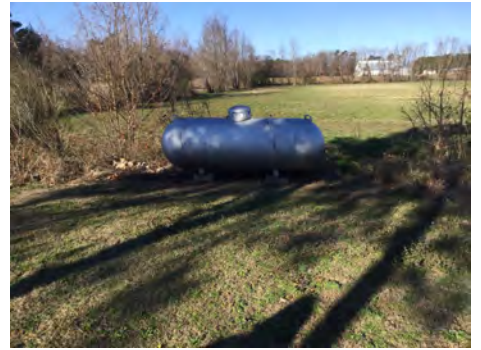
System: G3060 - Fuel Distribution

Note: Propane gas just for the kitchen

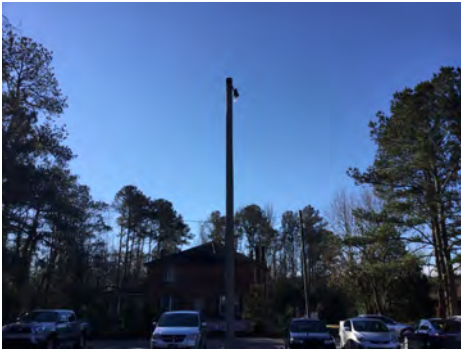
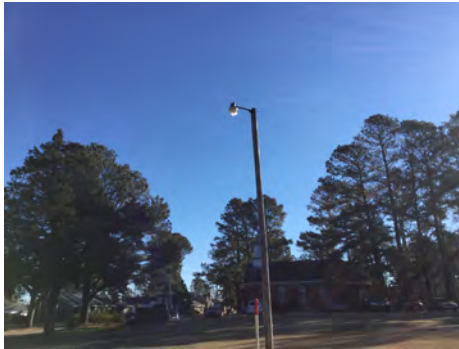
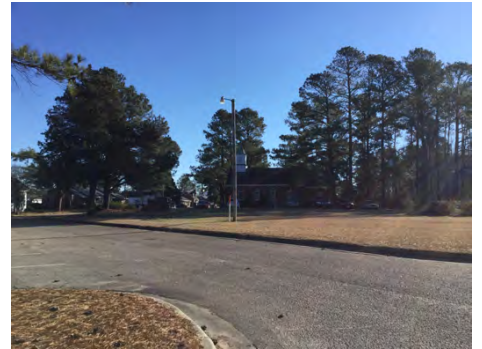
System: G4020 - Site Lighting

Note: The lighting system is inadequate and beyond its service life and should be replaced and more should be installed.

Notes: The lighting system is inadequate and beyond its service life and should be replaced and more should be installed.

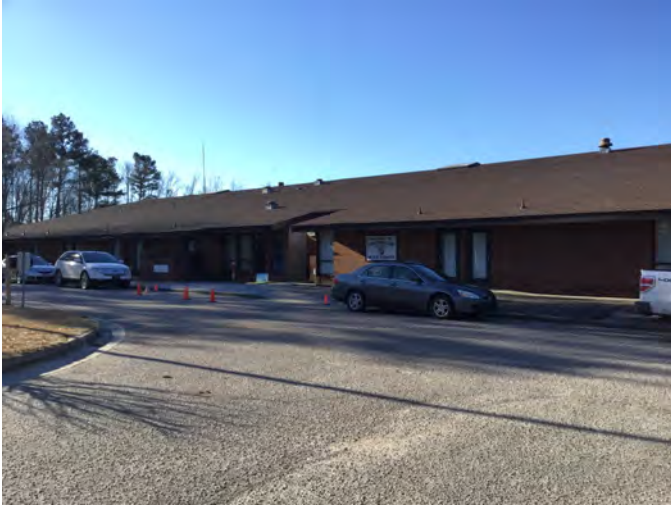
System: G2020 - Parking Lots

Location: Site

Distress: Inadequate

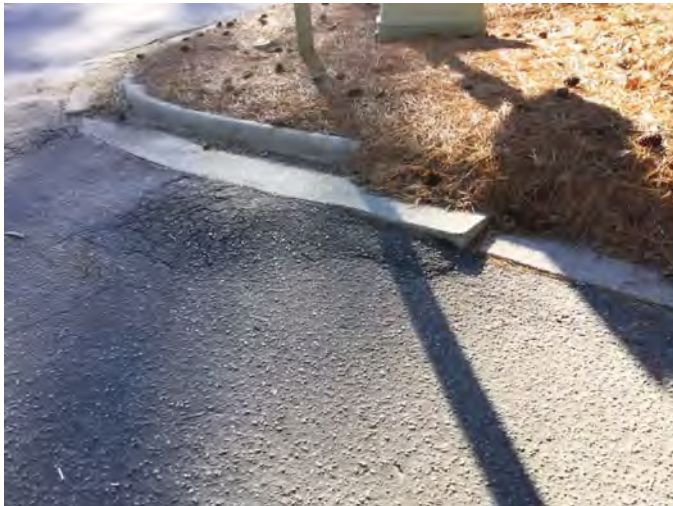
System: G2010 - Roadways

Location: Site
Distress: Damaged
Category: Deferred Maintenance
Priority: 3 - Necessary/Not Yet Critical (Years 2-5)
Correction: Resurface the roadway
Qty: 150.00
Unit of Measure: L.F.
Estimate: \$25,740.00
Assessor Name: Eduardo Lopez
Date Created: 01/30/2017

Notes: The roadways are cracking and they should be recoated and resealed.

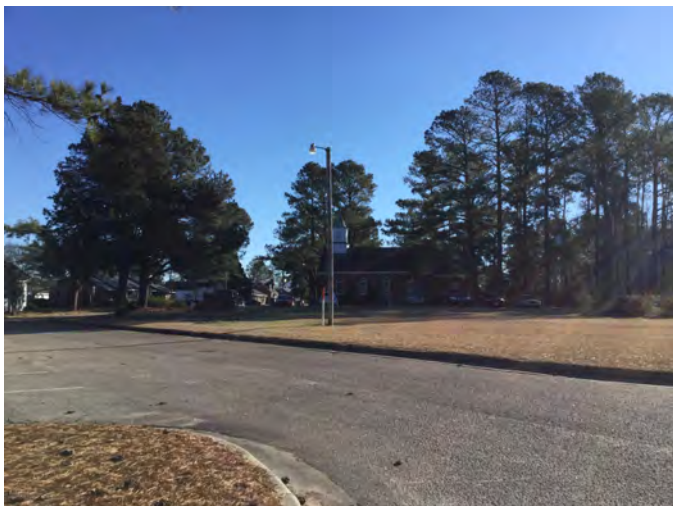
System: G4020 - Site Lighting

Location: Site
Distress: Beyond Service Life
Category: Deferred Maintenance
Priority: 3 - Necessary/Not Yet Critical (Years 2-5)
Correction: Renew System
Qty: 31,767.00
Unit of Measure: S.F.
Estimate: \$51,367.00
Assessor Name: Eduardo Lopez
Date Created: 02/09/2017

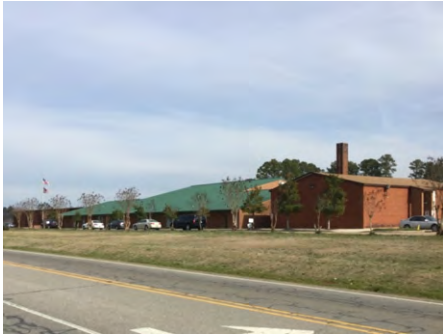
1). West Elevation - Feb 23, 2017

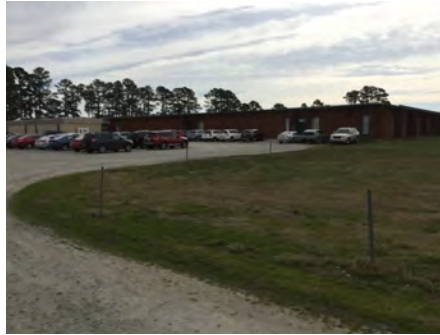
2). North Elevation - Feb 23, 2017

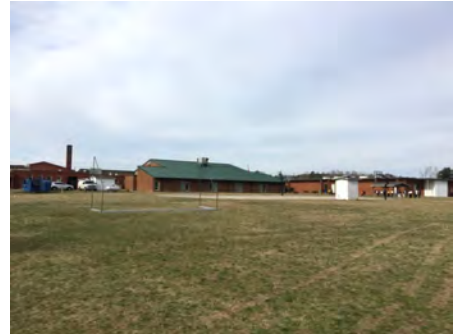
3). East Elevation - Feb 23, 2017

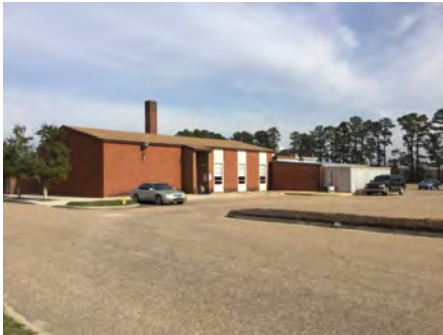
4). South Elevation - Feb 23, 2017

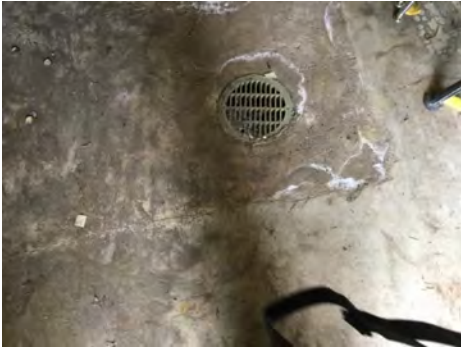
System: A1030 - Slab on Grade

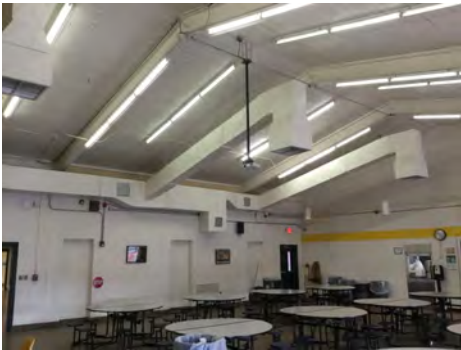
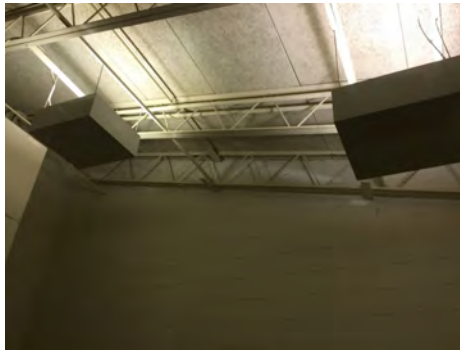
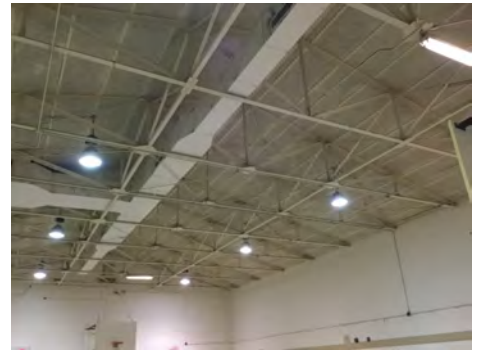
System: B1020 - Roof Construction

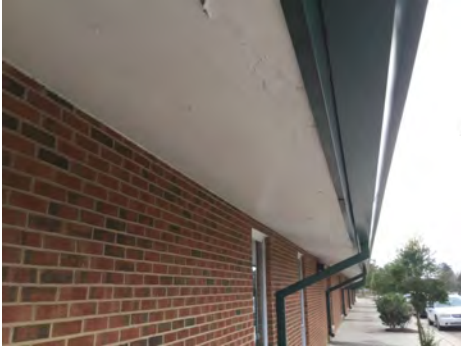
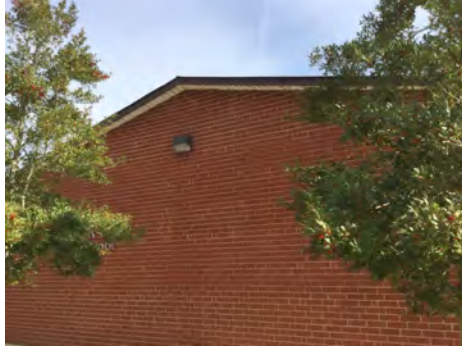
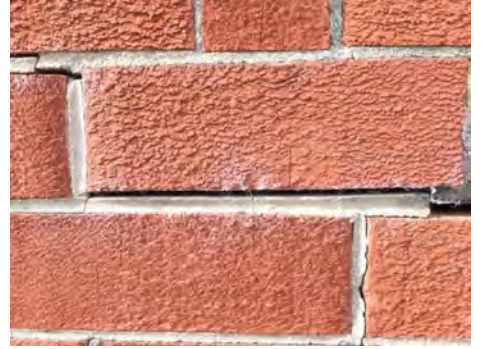
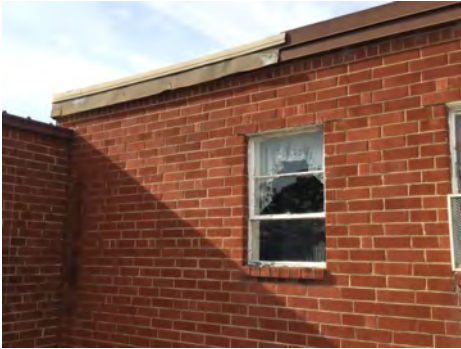
System: B2010 - Exterior Walls

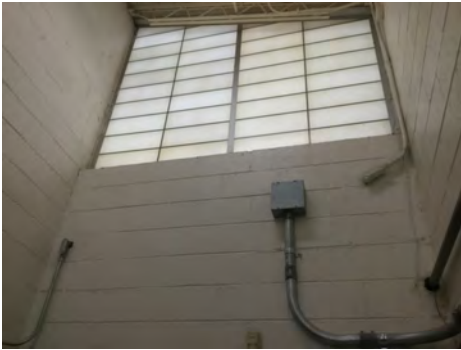
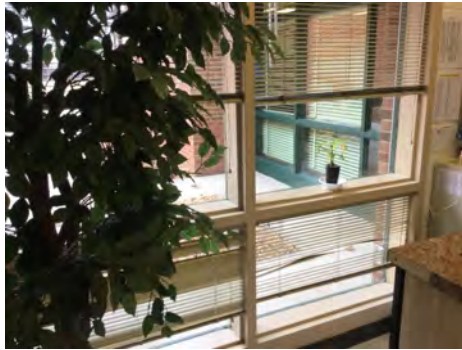
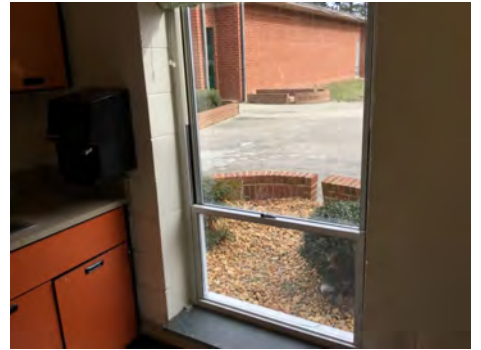
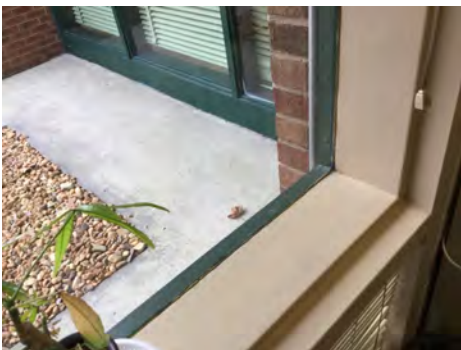
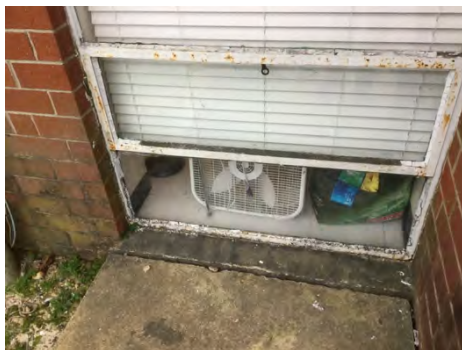
System: B2020 - Exterior Windows

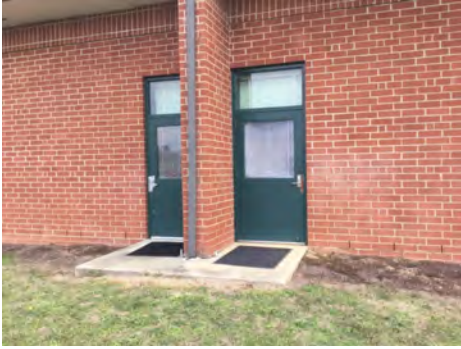
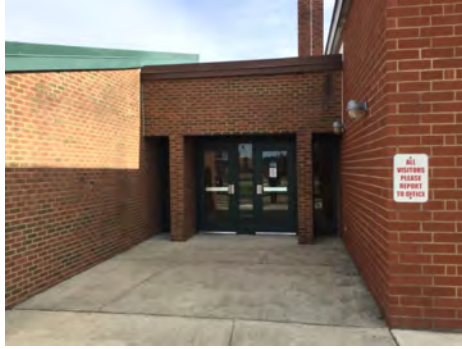
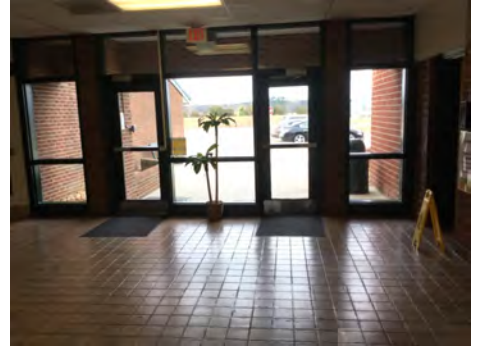
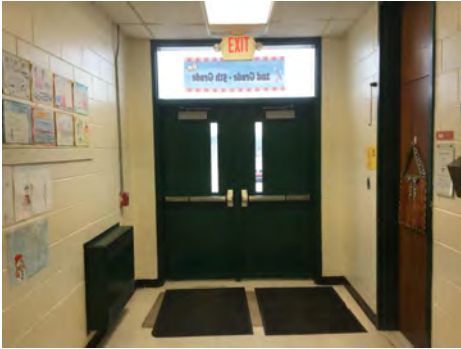
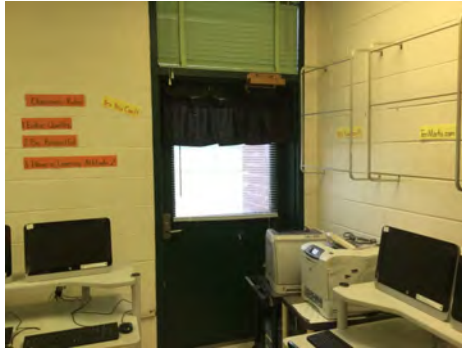
System: B2030 - Exterior Doors

Note: Exterior doors are generally well maintained in good operating condition with no deficiencies observed. Therefore, system renewal pushed 5 years.

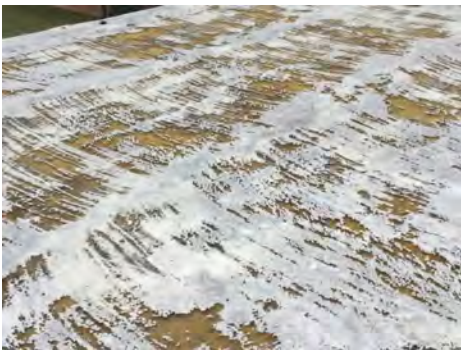
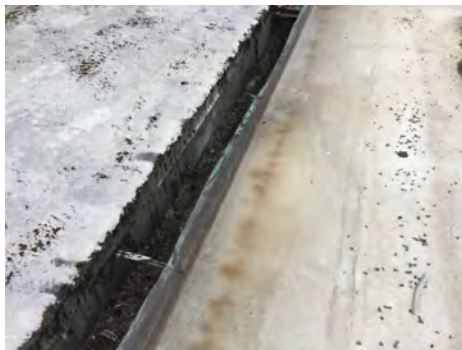
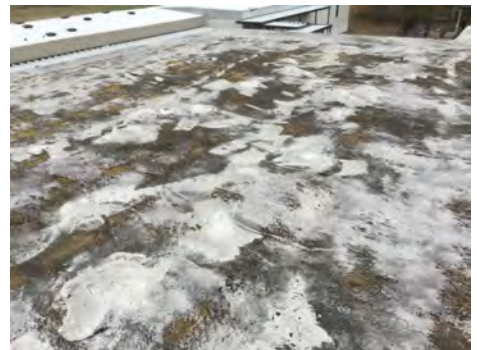
System: B3010105 - Built-Up

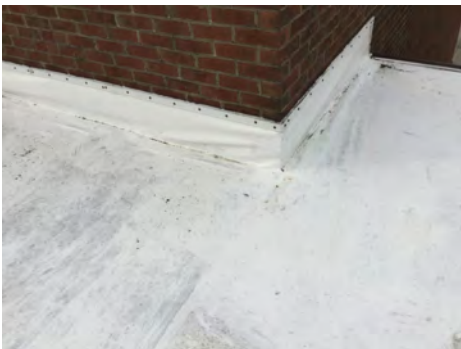
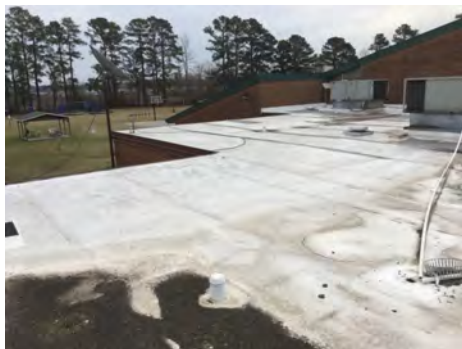
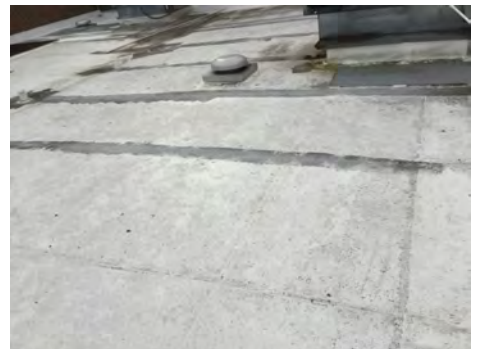
System: B3010120 - Single Ply Membrane

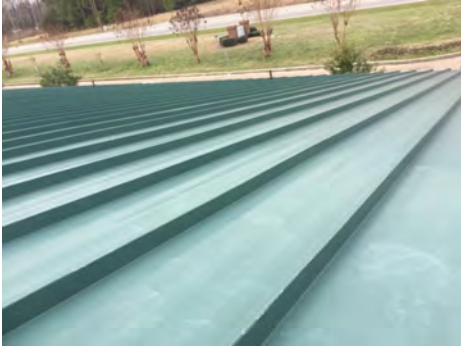
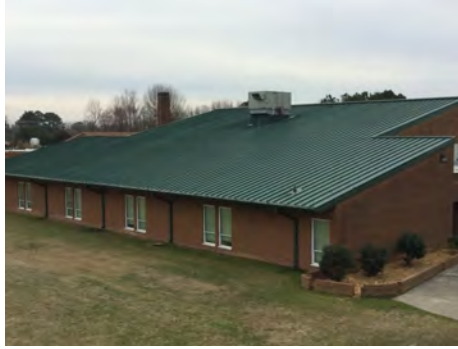
System: B3010130 - Preformed Metal Roofing

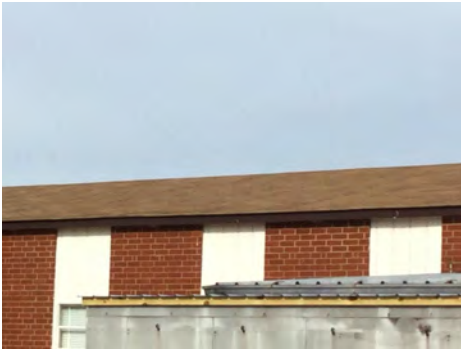
System: B3010140 - Asphalt Shingles

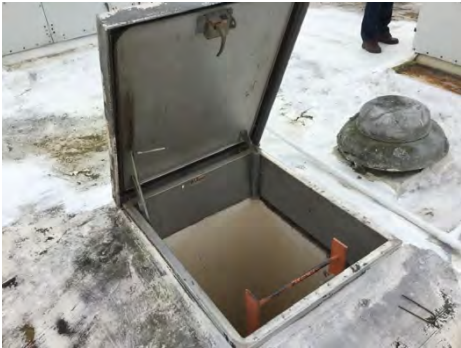
System: B3020 - Roof Openings

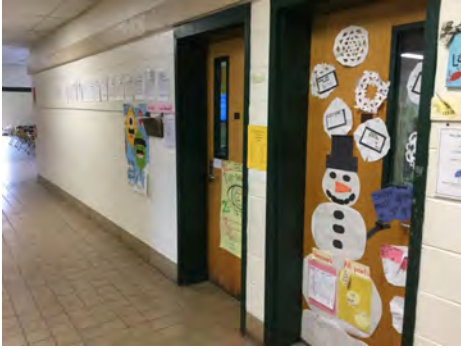
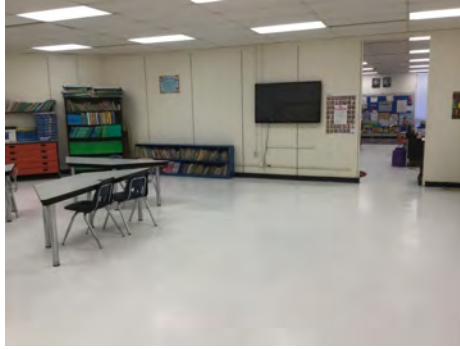
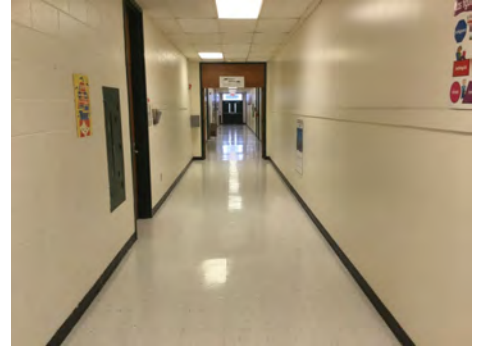
System: C1010 - Partitions

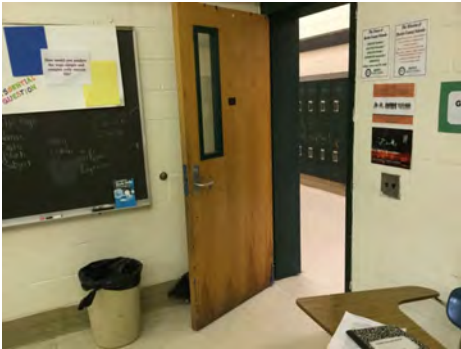
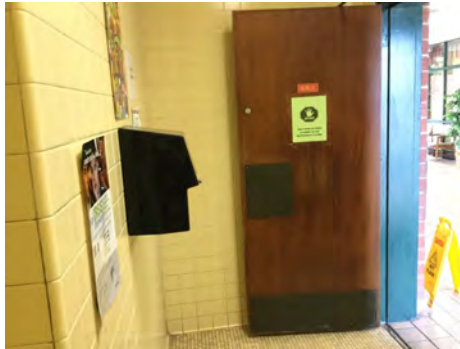
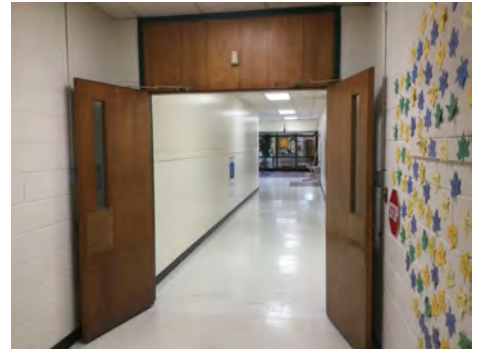
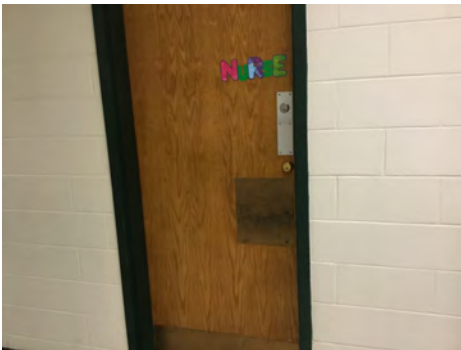
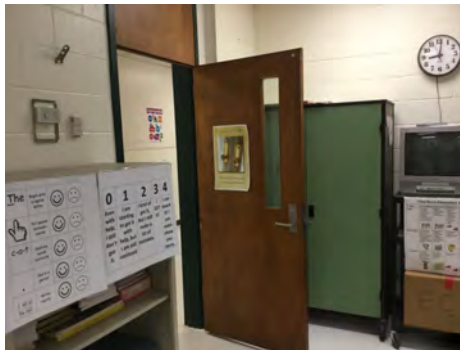
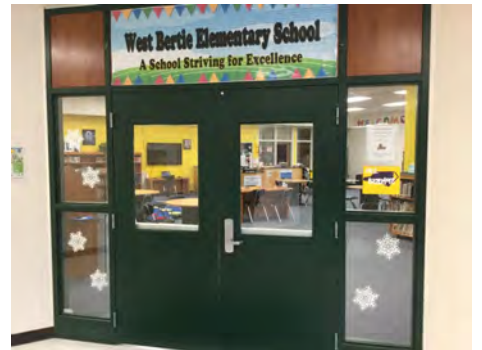
System: C1020 - Interior Doors

Note: Lever latches / locksets installed throughout in 2015. Finishes on doors are worn.

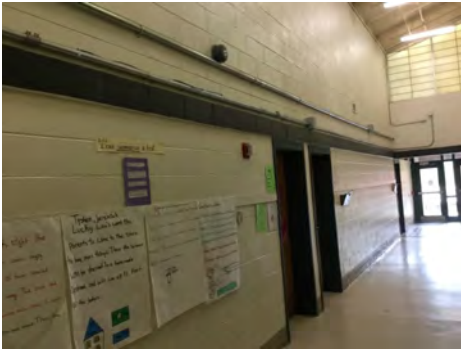
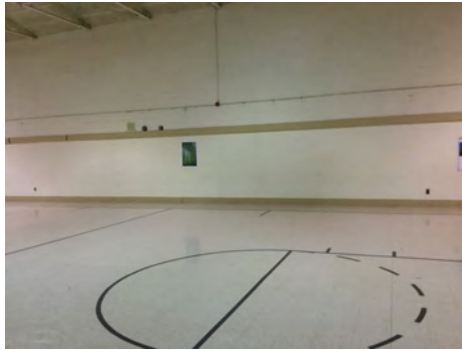
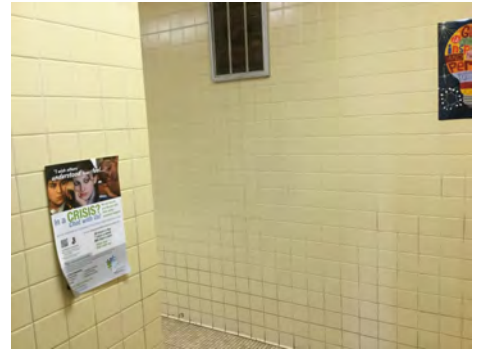
System: C3010 - Wall Finishes

Note: Interior painting is performed w/ in-house crews on an as-needed basis. No deficiencies observed.

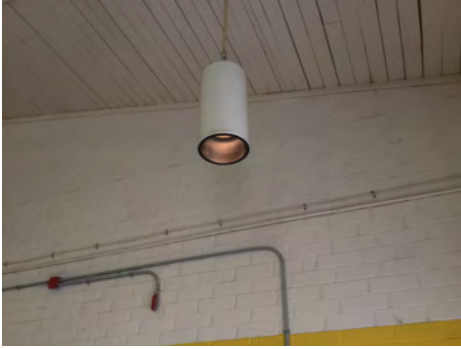
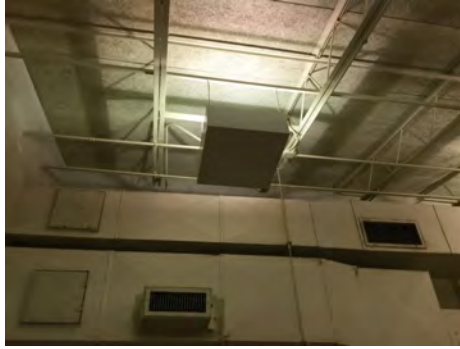
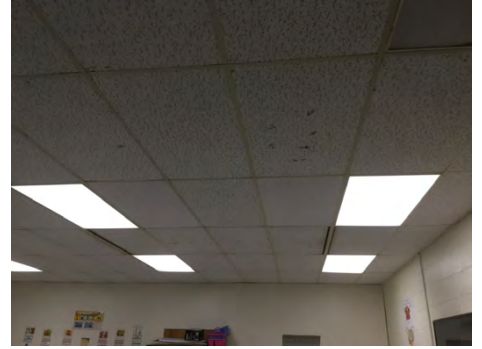
System: D5020 - Lighting

Note: Lamps converted to T-8 and ballasts replaced in existing fixtures.

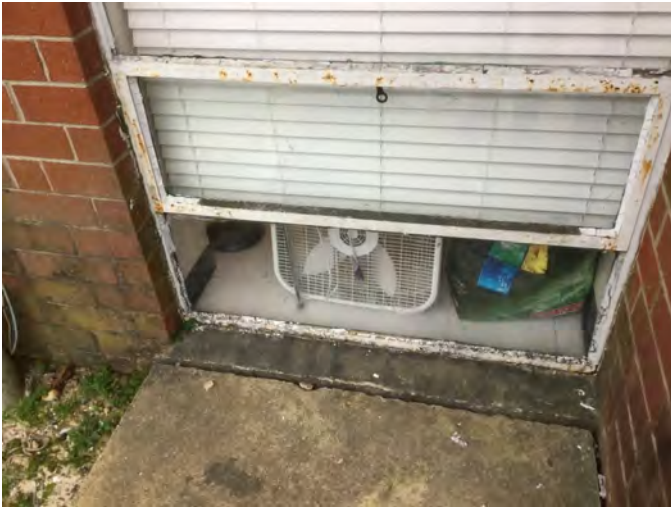
System: B2020 - Exterior Windows

Location: Throughout the building
Distress: Beyond Service Life
Category: Deferred Maintenance
Priority: 3 - Necessary/Not Yet Critical (Years 2-5)
Correction: Renew System
Qty: 53,135.00
Unit of Measure: S.F.
Estimate: \$548,831.00
Assessor Name: Ann Buerger Linden
Date Created: 02/23/2017

Notes: Exterior windows have exceeded their expected useful life. Particularly in older sections of the building, windows are single pane in steel frames in poor condition. System renewal is recommended.

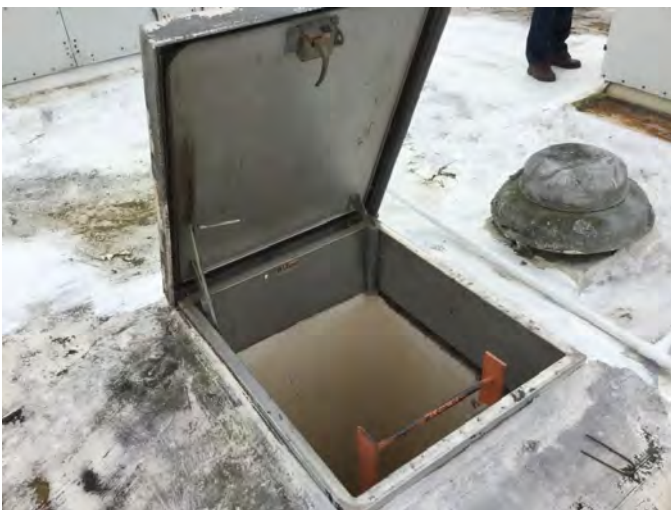
System: B3020 - Roof Openings

Location: Roof
Distress: Missing
Category: Deferred Maintenance
Priority: 3 - Necessary/Not Yet Critical (Years 2-5)
Correction: Renew System
Qty: 53,135.00
Unit of Measure: S.F.
Estimate: \$16,950.00
Assessor Name: Ann Buerger Linden
Date Created: 02/23/2017

Notes: While the roof hatch at the BUR section is functioning well, it is beyond its expected service life and should be considered for replacement at the time of roof replacement. There is no roof hatch to flat roof areas south of the metal roof section. Installation of a roof hatch to facilitate inspection and maintenance of roofs and roof mounted mechanical equipment is recommended.

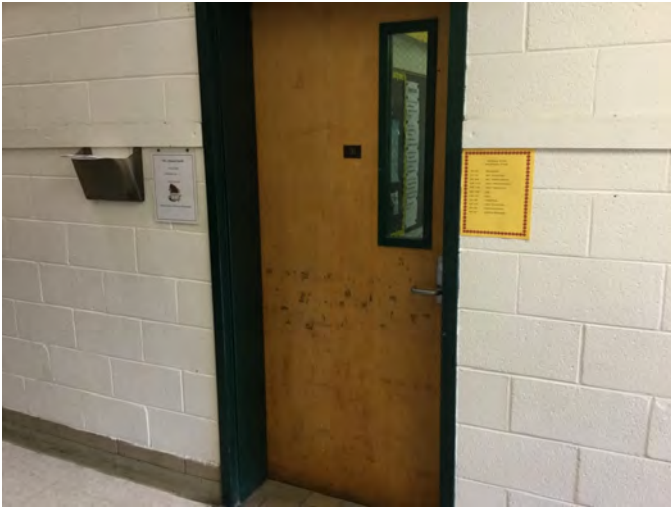
System: C1020 - Interior Doors

Location: Throughout the building
Distress: Damaged
Category: Deferred Maintenance / Appearance
Priority: 3 - Necessary/Not Yet Critical (Years 2-5)
Correction: Refinish 3'-0" x 7'-0" solid core wood door, interior
Qty: 53.00
Unit of Measure: Ea.
Estimate: \$10,004.28
Assessor Name: Ann Buerger Linden
Date Created: 02/23/2017

Notes: Interior doors were retrofitted with ADA compliant lever latches in 2015. Many doors are in only fair condition and are in need of refinishing.

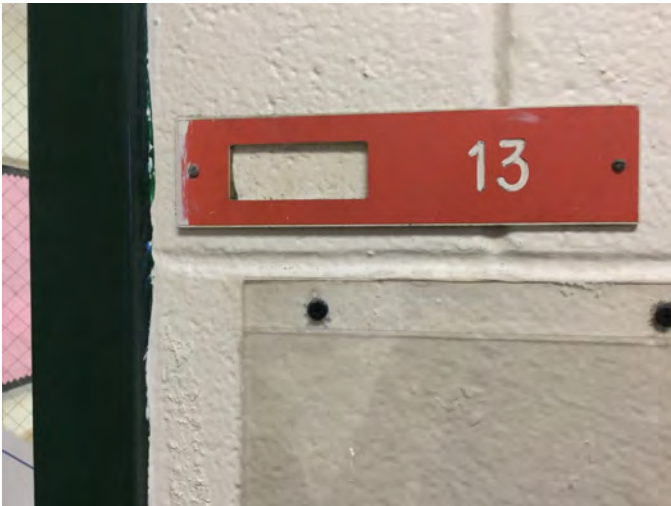
System: C1030 - Fittings

Location: Throughout the building
Distress: Beyond Service Life
Category: Deferred Maintenance
Priority: 3 - Necessary/Not Yet Critical (Years 2-5)
Correction: Renew System
Qty: 53,135.00
Unit of Measure: S.F.
Estimate: \$569,288.00
Assessor Name: Ann Buerger Linden
Date Created: 02/23/2017

Notes: Fittings throughout the building are in fair to poor condition. Signage and toilet partitions/accessories are not ADA compliant. Blackboard's are obsolete. Lockers are in poor condition. System renewal is recommended.

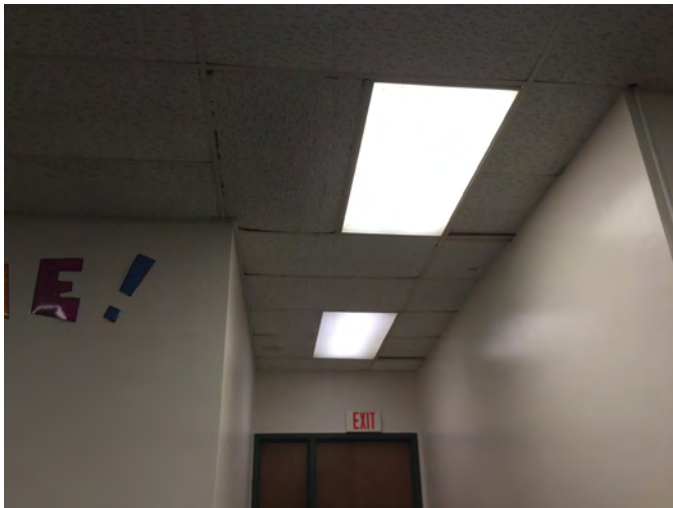
System: C3030 - Ceiling Finishes

Location: Throughout the building
Distress: Beyond Service Life
Category: Deferred Maintenance
Priority: 3 - Necessary/Not Yet Critical (Years 2-5)
Correction: Renew System
Qty: 53,135.00
Unit of Measure: S.F.
Estimate: \$641,180.00
Assessor Name: Ann Buerger Linden
Date Created: 02/23/2017

Notes: Ceiling finishes throughout the building are generally beyond their expected useful life. Grids are beginning to yellow. Many tile are damaged due to roof leaks and there are many mismatched tile throughout the school due to replacements. System renewal is recommended.

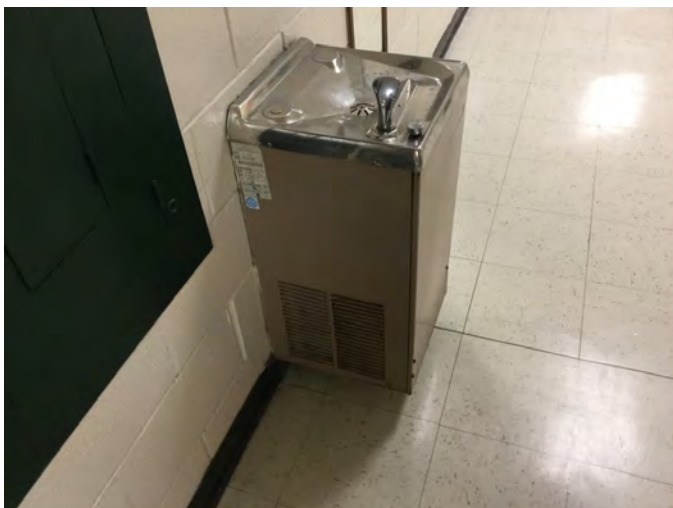
System: D2010 - Plumbing Fixtures

Location: Throughout the building
Distress: Beyond Service Life
Category: Deferred Maintenance / Accessibility Code Compliance
Priority: 3 - Necessary/Not Yet Critical (Years 2-5)
Correction: Renew System
Qty: 53,135.00
Unit of Measure: S.F.
Estimate: \$670,989.00
Assessor Name: Ann Buerger Linden
Date Created: 02/23/2017

Notes: While lav sinks have been retrofitted with spring-loaded faucets for water conservation, in general plumbing fixtures are not low-flow models. Also, restrooms and drinking fountains are not ADA compliant. System renewal is recommended.

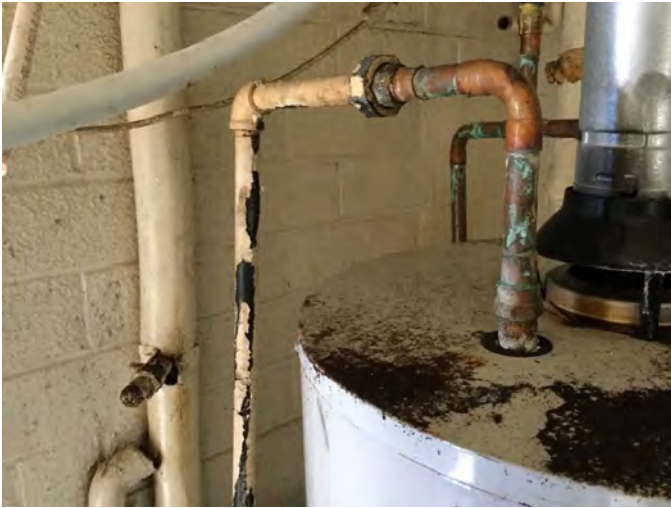
System: D2020 - Domestic Water Distribution

Location: Throughout the building
Distress: Beyond Service Life
Category: Deferred Maintenance
Priority: 3 - Necessary/Not Yet Critical (Years 2-5)
Correction: Renew System
Qty: 53,135.00
Unit of Measure: S.F.
Estimate: \$57,280.00
Assessor Name: Ann Buerger Linden
Date Created: 02/23/2017

Notes: Water supply piping includes both copper and galvanized sections. The system as a whole is beyond its expected useful life. System renewal is recommended.

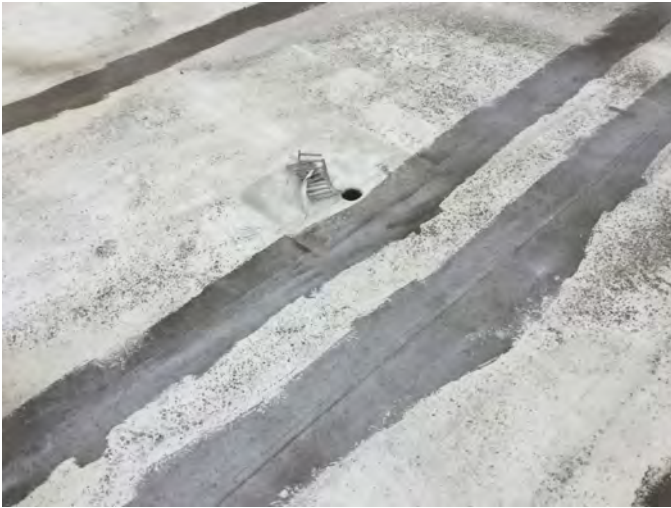
System: D2040 - Rain Water Drainage

Location: Roof drains
Distress: Beyond Service Life
Category: Deferred Maintenance
Priority: 3 - Necessary/Not Yet Critical (Years 2-5)
Correction: Renew System
Qty: 53,135.00
Unit of Measure: S.F.
Estimate: \$81,243.00
Assessor Name: Ann Buerger Linden
Date Created: 02/23/2017

Notes: The roof drainage system is beyond its expected life. While no leaks were observed or reported, the system is old and likely to cause problems. At the single ply roof, the roofer did not flash properly to allow installation of drain baskets.

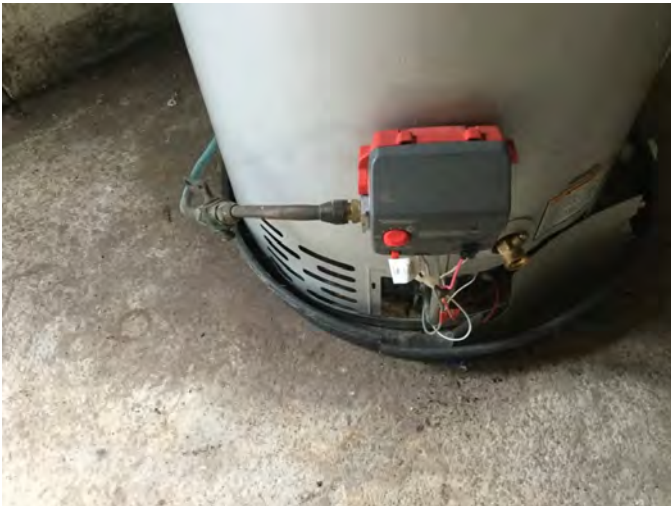
System: D2090 - Other Plumbing Systems -Propane

Location: Mechanical room and kitchen
Distress: Beyond Service Life
Category: Deferred Maintenance
Priority: 3 - Necessary/Not Yet Critical (Years 2-5)
Correction: Renew System
Qty: 53,135.00
Unit of Measure: S.F.
Estimate: \$9,936.00
Assessor Name: Ann Buerger Linden
Date Created: 02/23/2017

Notes: The gas piping system has exceeded its useful life. System renewal is recommended for safety.

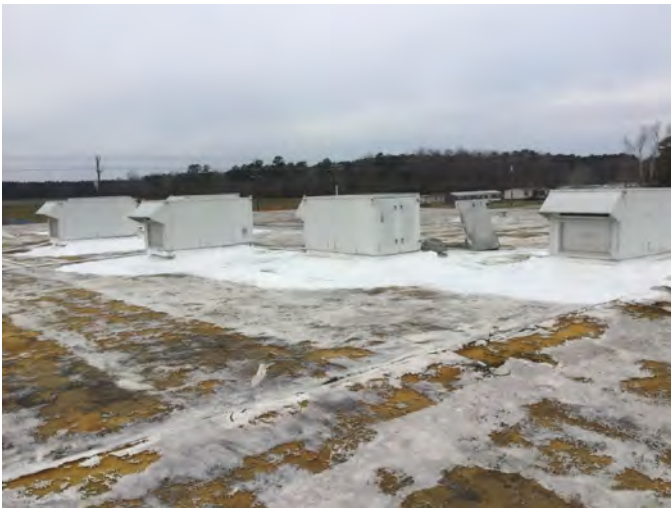
System: D3050 - Terminal & Package Units

Location: Throughout the building
Distress: Beyond Service Life
Category: Deferred Maintenance
Priority: 3 - Necessary/Not Yet Critical (Years 2-5)
Correction: Renew System
Qty: 53,135.00
Unit of Measure: S.F.
Estimate: \$781,456.00
Assessor Name: Ann Buerger Linden
Date Created: 02/23/2017

Notes: The water to air heat pumps at the north wing are well beyond their expected life and require a lot of maintenance. Other air to air heat pumps on the remainder of the building have exceeded their expected useful life and system renewal is recommended to ensure performance.

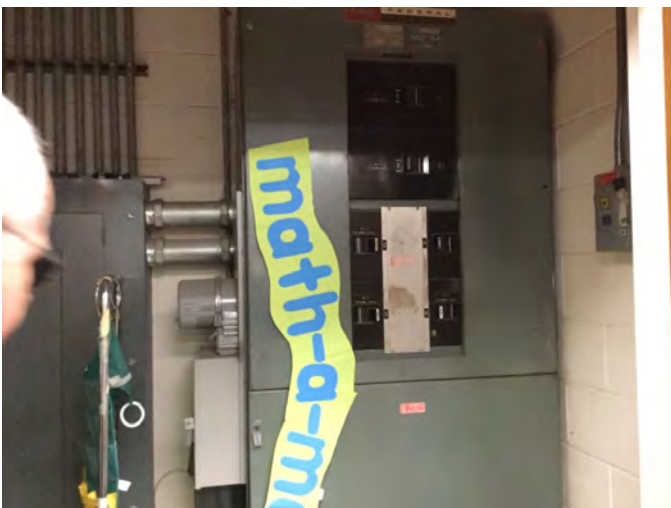
System: D5010 - Electrical Service/Distribution

Location: At MDPs
Distress: Beyond Service Life
Category: Deferred Maintenance
Priority: 3 - Necessary/Not Yet Critical (Years 2-5)
Correction: Renew System
Qty: 53,135.00
Unit of Measure: S.F.
Estimate: \$98,778.00
Assessor Name: Ann Buerger Linden
Date Created: 02/23/2017

Notes: There are two MDP panels in the building and both have exceeded their expected useful life. Review service size in light of the recommendation to renew distribution systems. The south service is located in a room with wet utilities. System renewal is recommended.

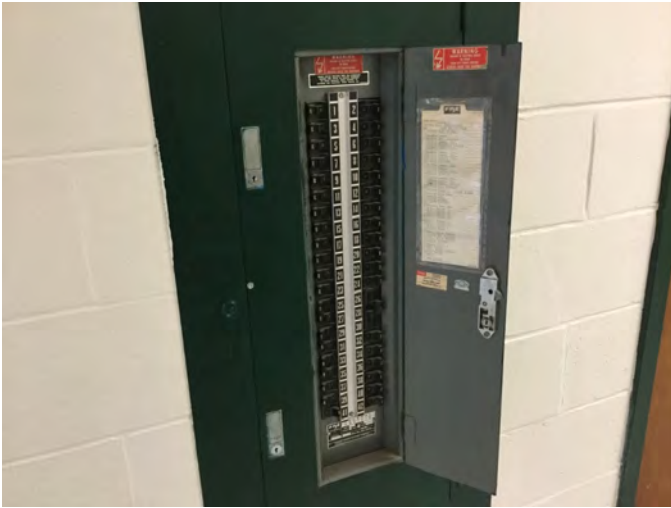
System: D5020 - Branch Wiring

Location: Throughout the building
Distress: Beyond Service Life
Category: Deferred Maintenance
Priority: 3 - Necessary/Not Yet Critical (Years 2-5)
Correction: Renew System
Qty: 53,135.00
Unit of Measure: S.F.
Estimate: \$295,749.00
Assessor Name: Ann Buerger Linden
Date Created: 02/23/2017

Notes: The branch wiring system is beyond its expected useful life. There are insufficient outlets to meet modern needs. There are not GFCI outlets in wet areas throughout the building. System renewal is recommended.

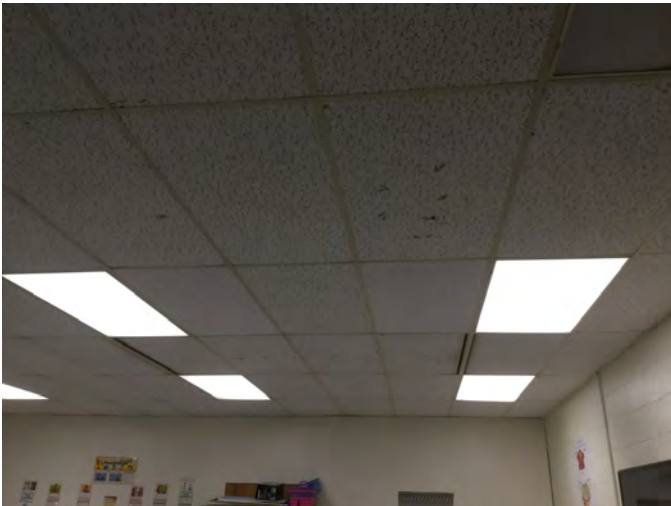
System: D5020 - Lighting

Location: Throughout the building
Distress: Beyond Service Life
Category: Deferred Maintenance
Priority: 3 - Necessary/Not Yet Critical (Years 2-5)
Correction: Renew System
Qty: 53,135.00
Unit of Measure: S.F.
Estimate: \$696,706.00
Assessor Name: Ann Buerger Linden
Date Created: 02/23/2017

Notes: While most fixtures have been upgraded with T-8 bulbs and ballasts, the fixtures themselves are beyond their expected useful life. The up-lights used in portions of the newer building are difficult to maintain. System renewal is recommended.

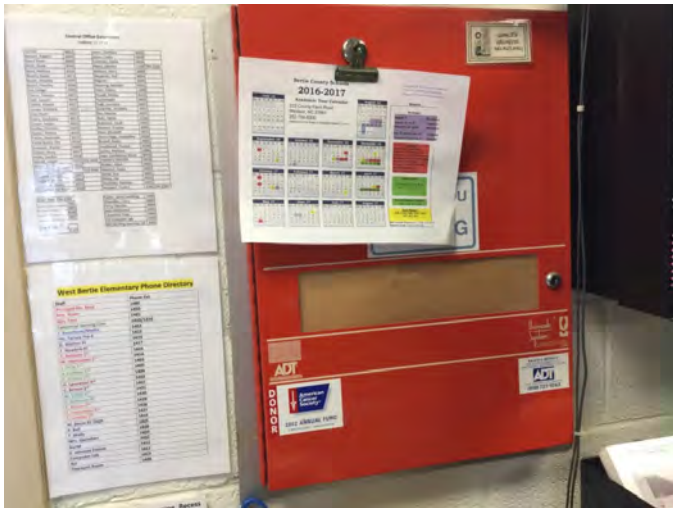
System: D5030910 - Fire Alarm Systems

Location: Throughout the building
Distress: Beyond Service Life
Category: Deferred Maintenance / Life Safety Code Compliance
Priority: 3 - Necessary/Not Yet Critical (Years 2-5)
Correction: Renew System
Qty: 53,135.00
Unit of Measure: S.F.
Estimate: \$198,140.00
Assessor Name: Ann Buerger Linden
Date Created: 02/23/2017

Notes: The fire alarm system is original and beyond its expected life. System renewal is recommended to ensure reliability of this life safety system.

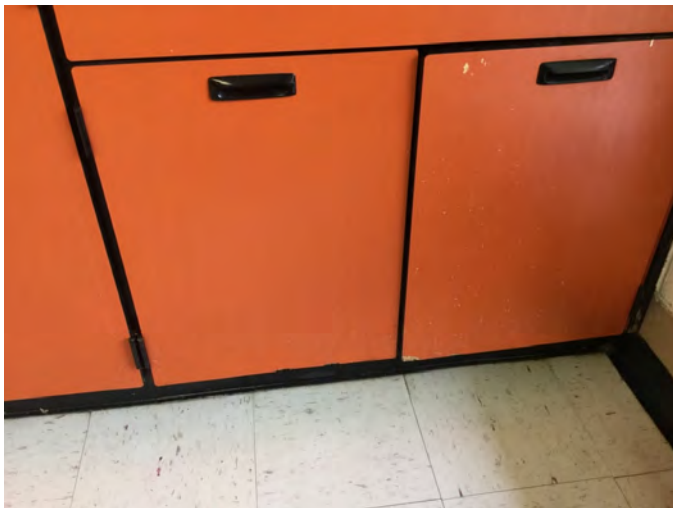
System: E2010 - Fixed Furnishings

Location: Throughout the building
Distress: Beyond Service Life
Category: Deferred Maintenance
Priority: 3 - Necessary/Not Yet Critical (Years 2-5)
Correction: Renew System
Qty: 53,135.00
Unit of Measure: S.F.
Estimate: \$340,755.00
Assessor Name: Ann Buerger Linden
Date Created: 02/23/2017

Notes: While most fixed furnishings are in functional condition, the cabinetry is showing signs of wear and tear. System renewal is recommended.

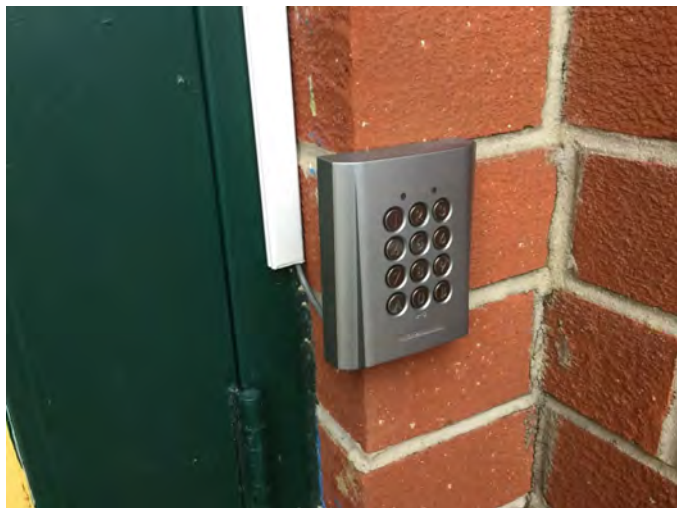
System: D5030810 - Security & Detection Systems

Location: Throughout the building
Distress: Missing
Category: Deferred Maintenance
Priority: 4 - Recommended (Years 6-10)
Correction: Renew System
Qty: 53,135.00
Unit of Measure: S.F.
Estimate: \$109,299.00
Assessor Name: Ann Buerger Linden
Date Created: 02/23/2017

Notes: While door security is up to date, this campus does not have a camera monitoring system. Installation of camera monitoring is recommended.

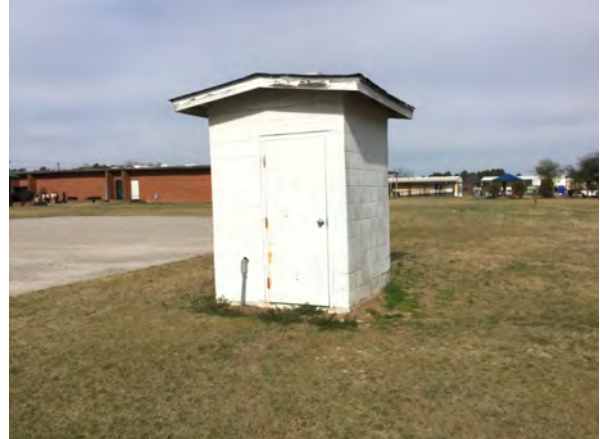
Originally constructed when the school was on well water, this building is not currently in use. The pumps and equipment are reportedly functional, but the system does not meet current clean water standards for water treatment. Demolition is recommended as there is no apparent practical use for this structure.

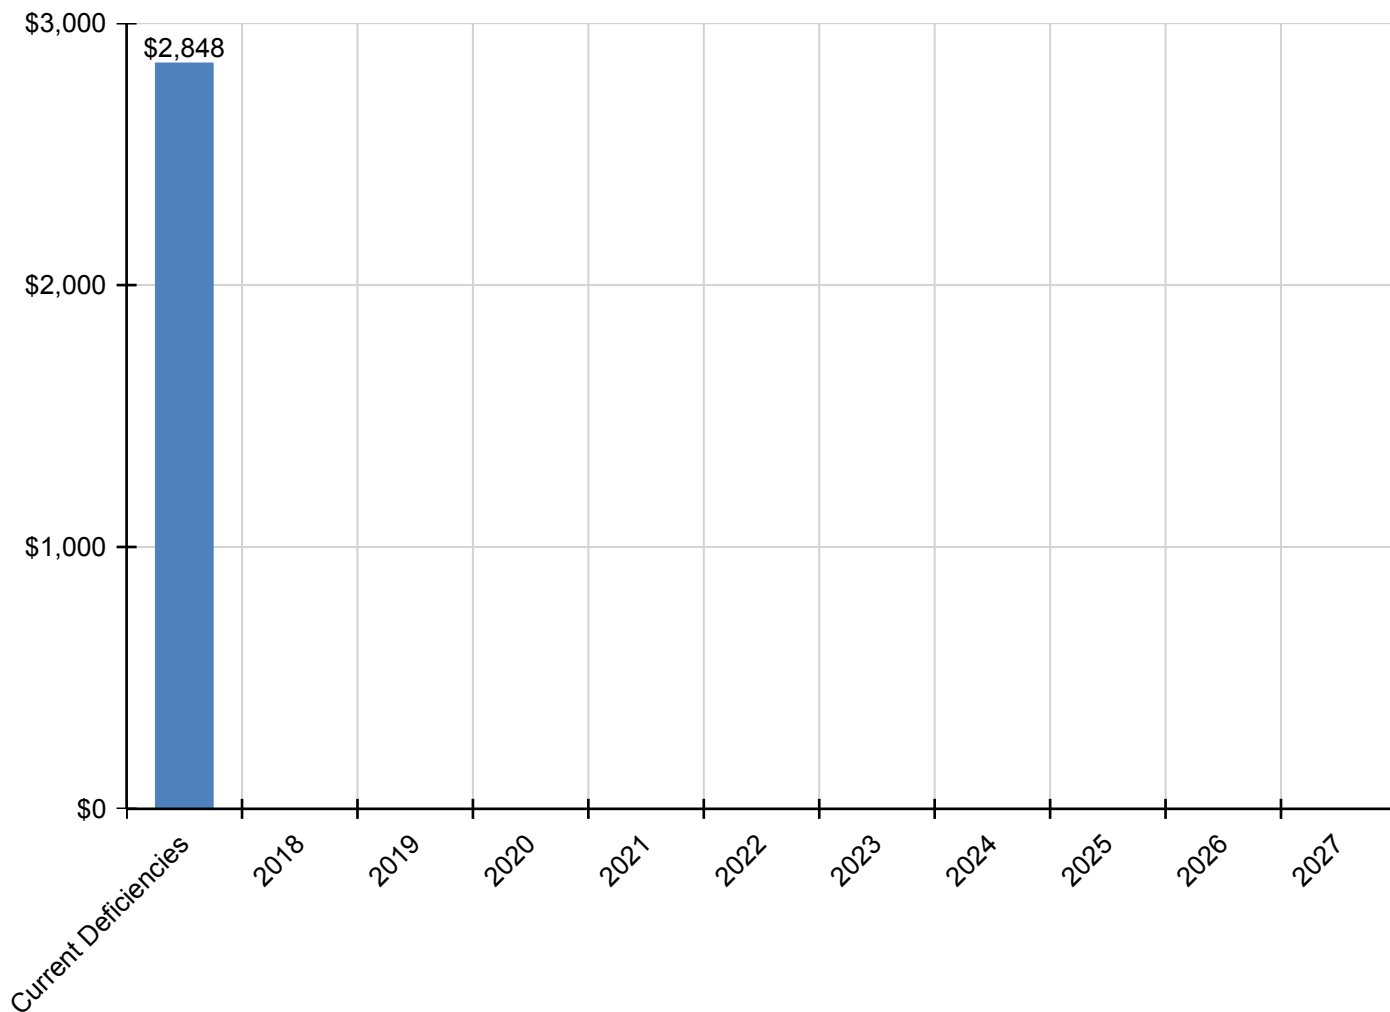
The following chart shows the current building deficiencies and forecasting capital renewal or sustainment requirements over the next ten years.

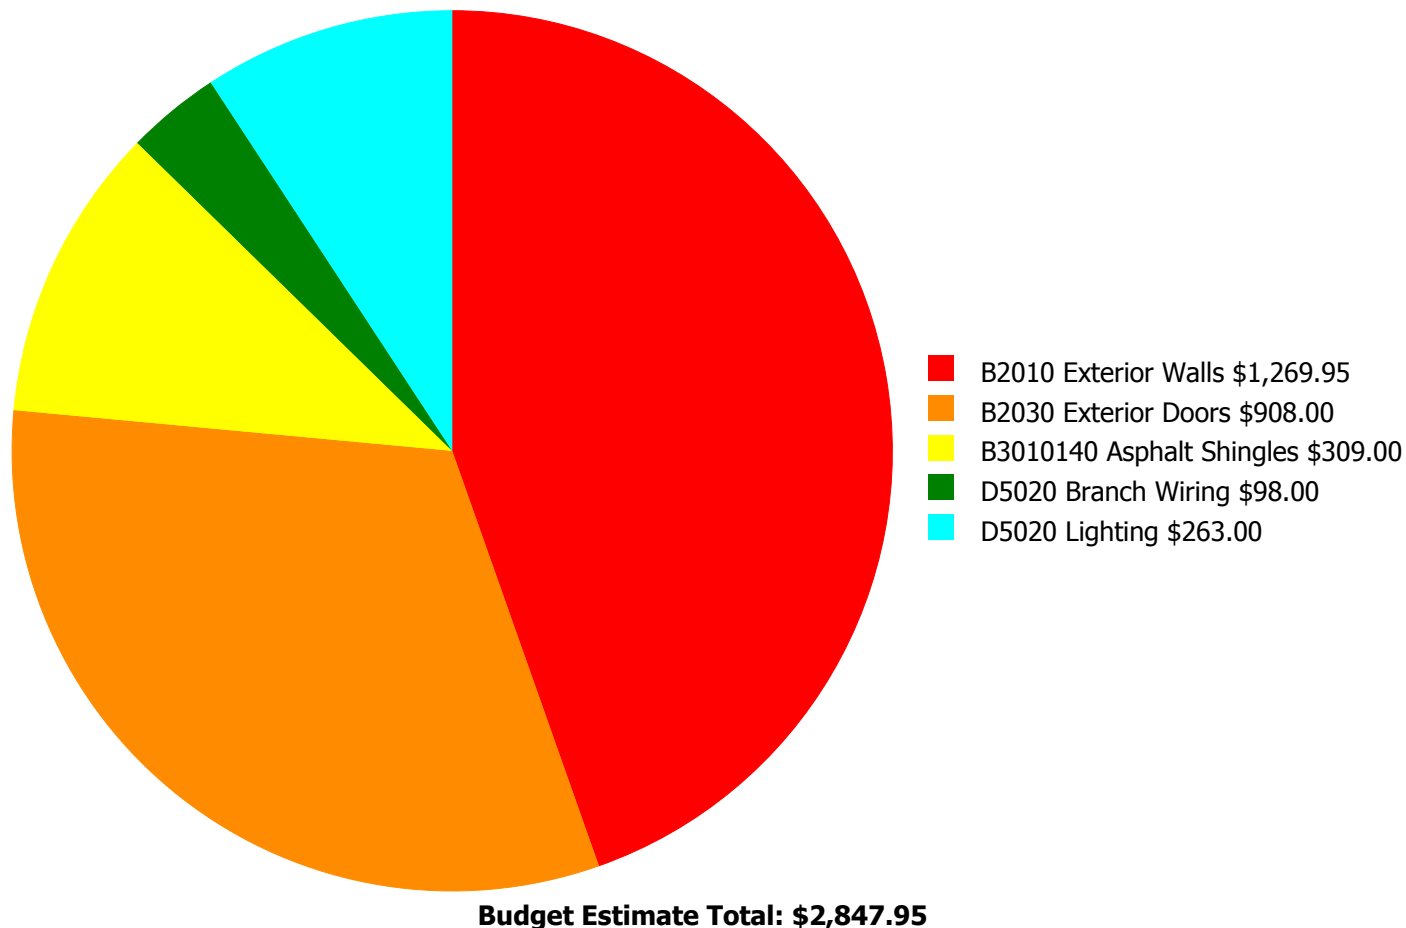
Current deficiencies included assemblies that have reached or exceeded their design life or components of the assemblies that are in need of repair. Assemblies that have reached their design life are identified as current deficiencies and assigned the distress 'Beyond Useful Life'. The following chart lists all current deficiencies associated with this facility.
