NC School District/080 Bertie County/Middle School

Bertie Middle

Campus Assessment Report

March 8, 2017

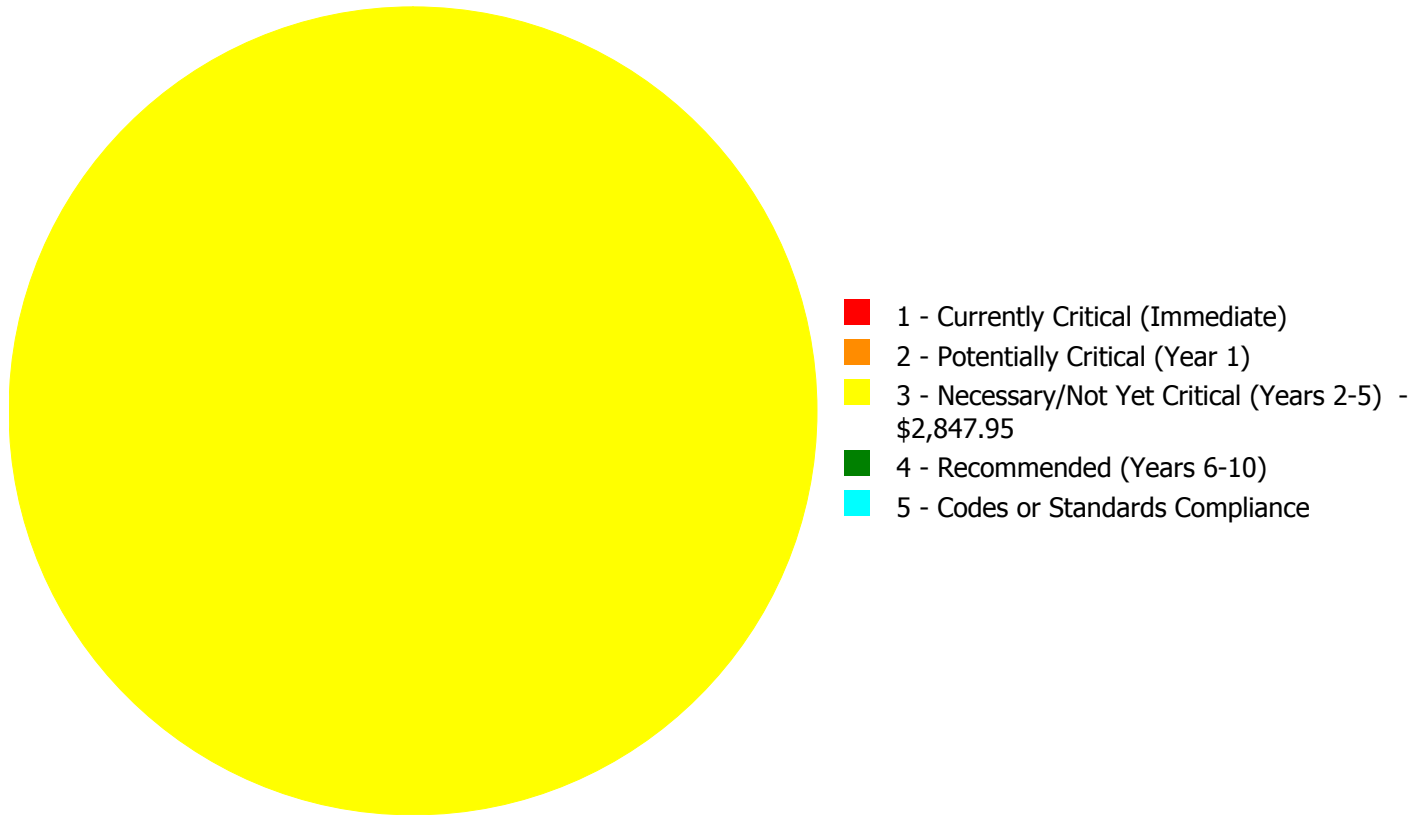
The following chart shows the total repair costs broken down by priority. Assessors assigned deficiencies within eCOMET to one of the following priority categories:

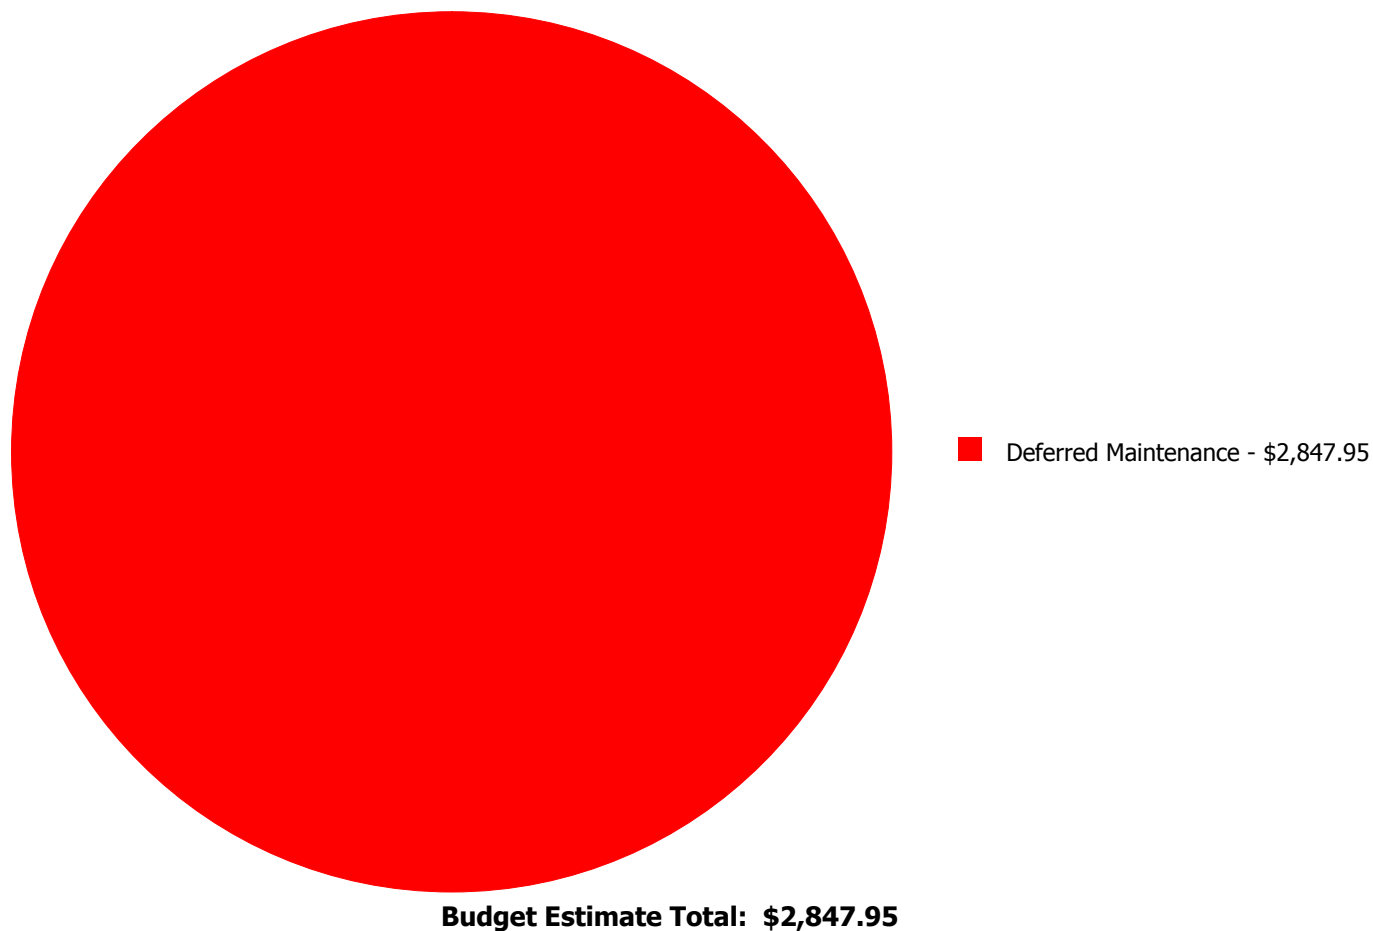
The following chart shows the total repair costs broken down by deficiency categories. Assessors assigned deficiencies to one of the following categories:

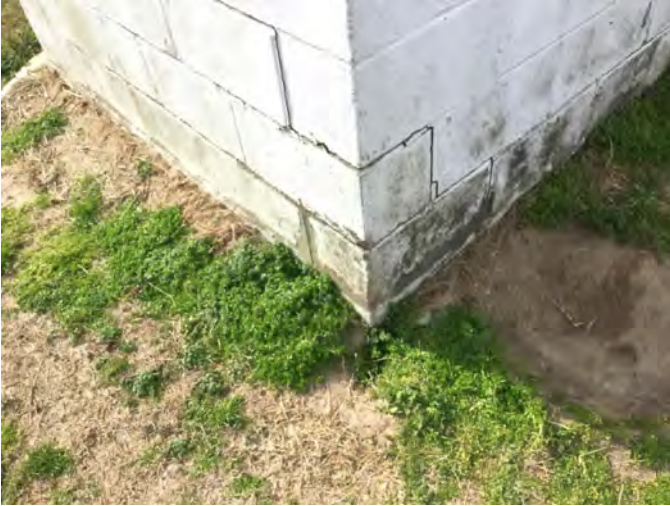
System: B2010 - Exterior Walls

Location: Exterior walls
Distress: Damaged
Category: Deferred Maintenance
Priority: 3 - Necessary/Not Yet Critical (Years 2-5)
Correction: Point and refinish painted concrete block wall, 1st floor
Qty: 1.60
Unit of Measure: C.S.F.
Estimate: \$1,269.95
Assessor Name: Eduardo Lopez
Date Created: 02/23/2017

Notes: Exterior walls are cracked. Repairs are recommended.

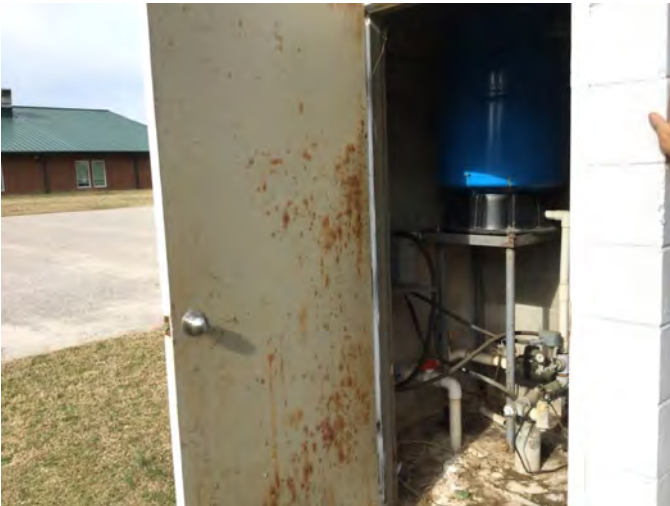
System: B2030 - Exterior Doors

Location: Exterior door
Distress: Beyond Service Life
Category: Deferred Maintenance
Priority: 3 - Necessary/Not Yet Critical (Years 2-5)
Correction: Renew System
Qty: 25.00
Unit of Measure: S.F.
Estimate: \$908.00
Assessor Name: Eduardo Lopez
Date Created: 02/21/2017

Notes: The exterior door is in rusted condition. Replacement is recommended.

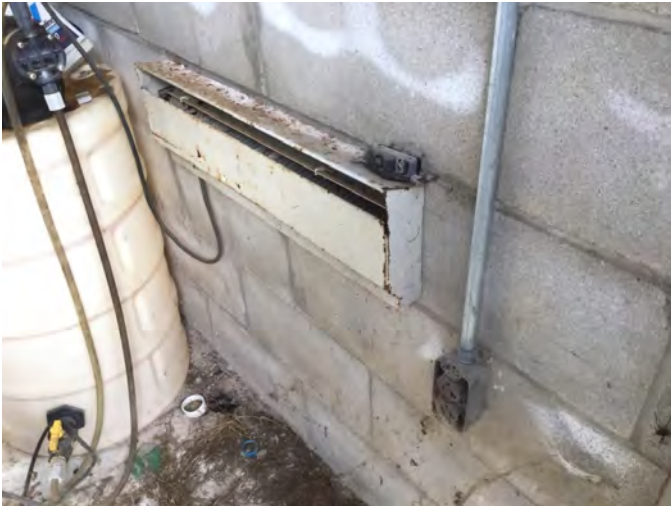
System: D5020 - Branch Wiring

Location: Interior
Distress: Damaged
Category: Deferred Maintenance
Priority: 3 - Necessary/Not Yet Critical (Years 2-5)
Correction: Renew System
Qty: 25.00
Unit of Measure: S.F.
Estimate: \$98.00
Assessor Name: Eduardo Lopez
Date Created: 02/21/2017

Notes: The branch wiring system is beyond its expected useful life and in poor condition. There not GFCI protection on the outlet. System renewal is recommended.

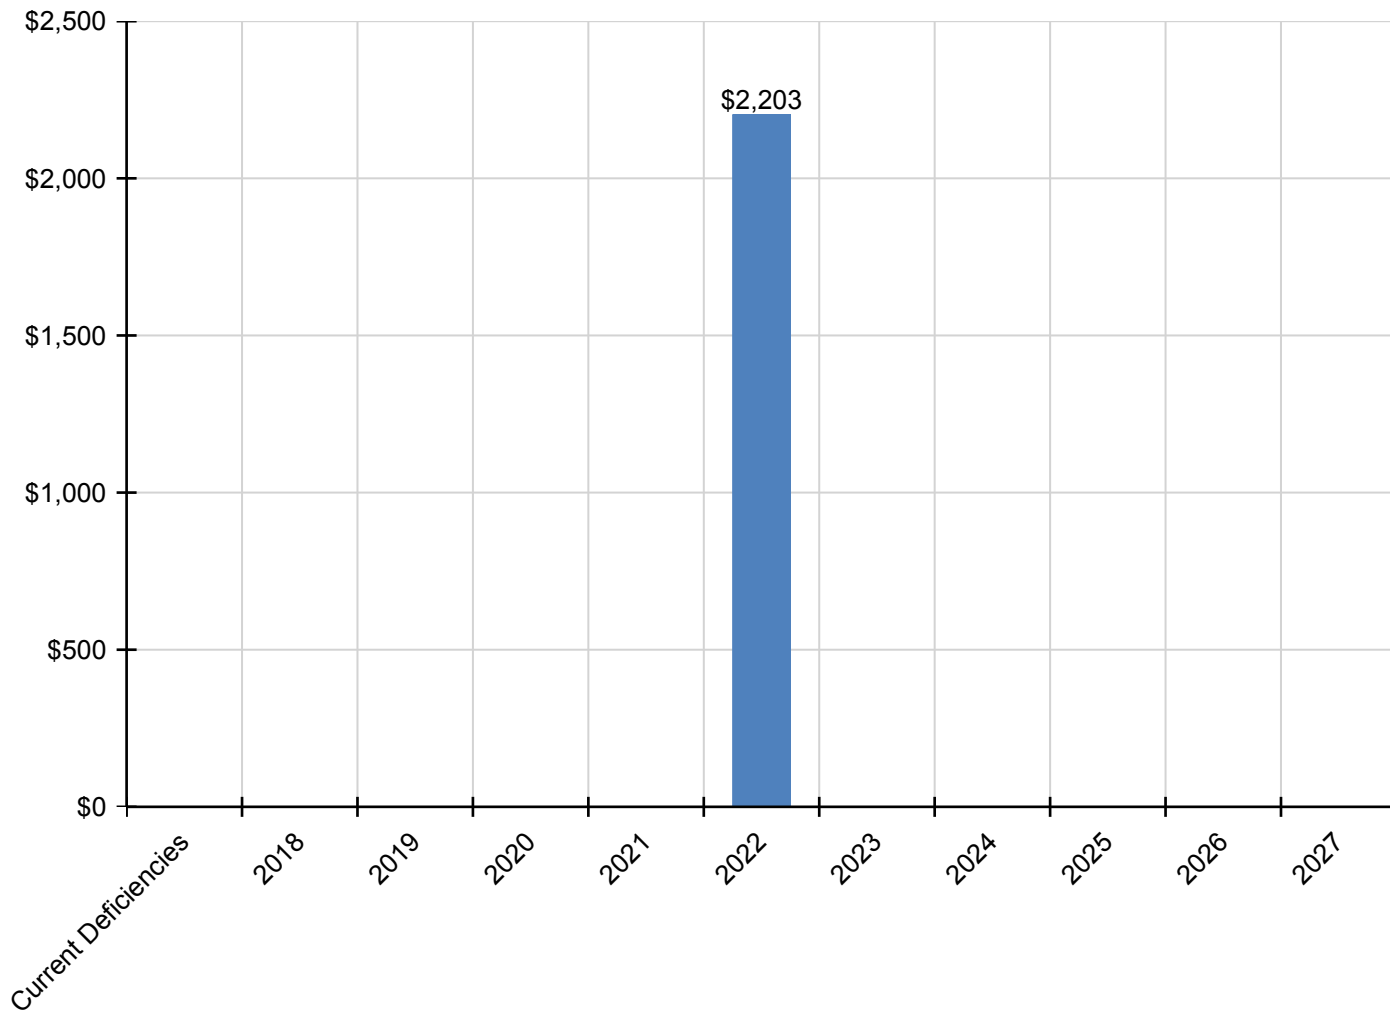
The following chart shows the current building deficiencies and forecasting capital renewal or sustainment requirements over the next ten years.

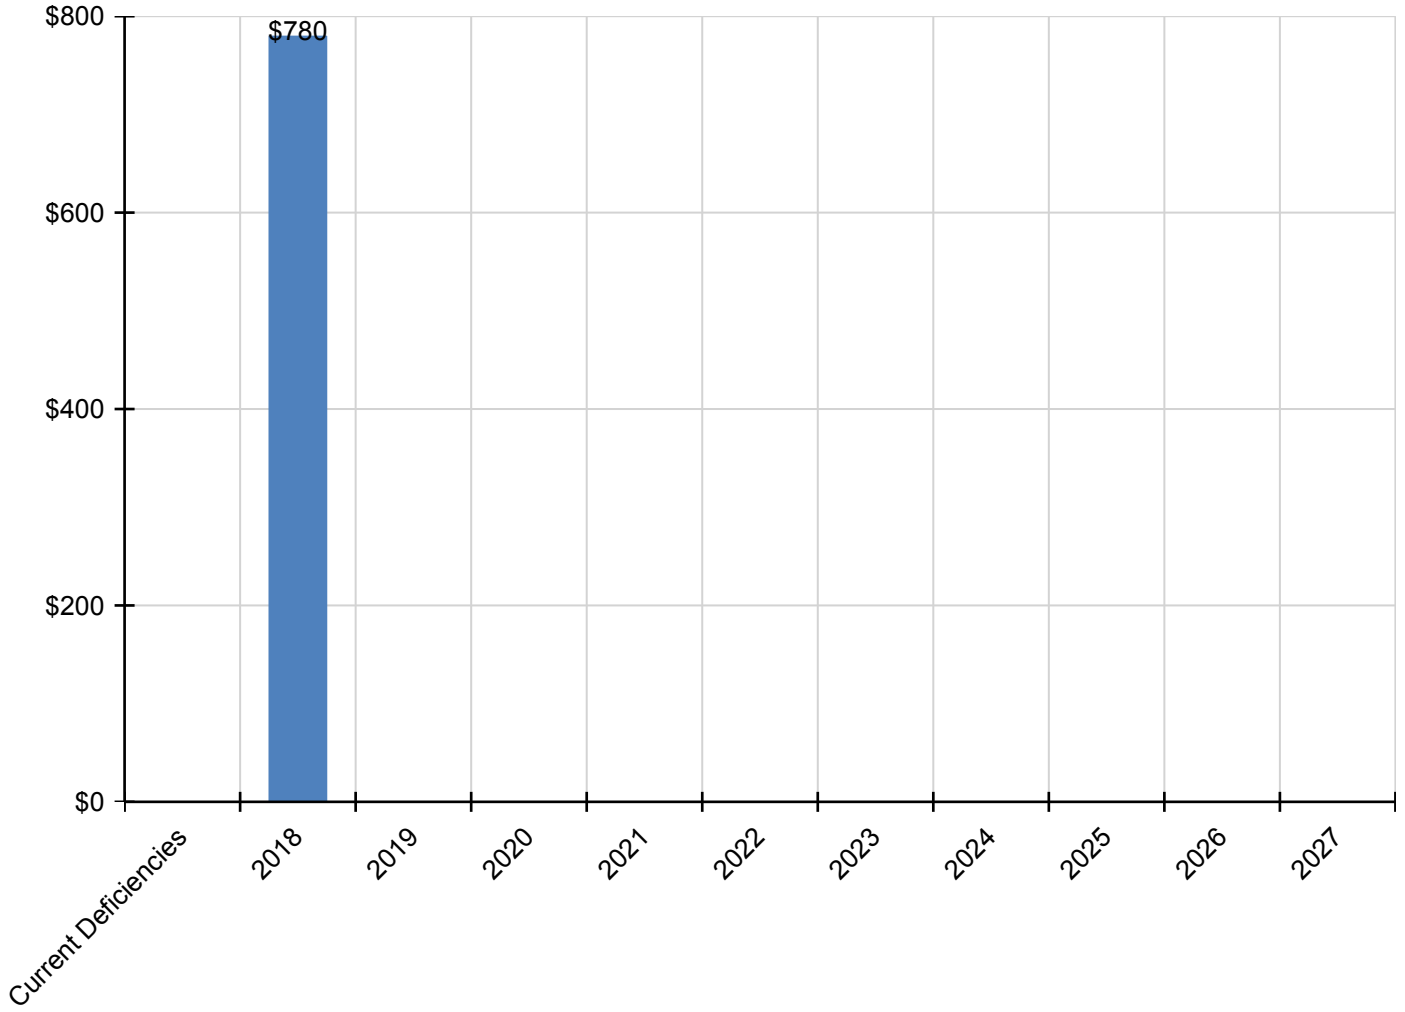
The following chart shows the current building deficiencies and forecasting capital renewal or sustainment requirements over the next ten years.

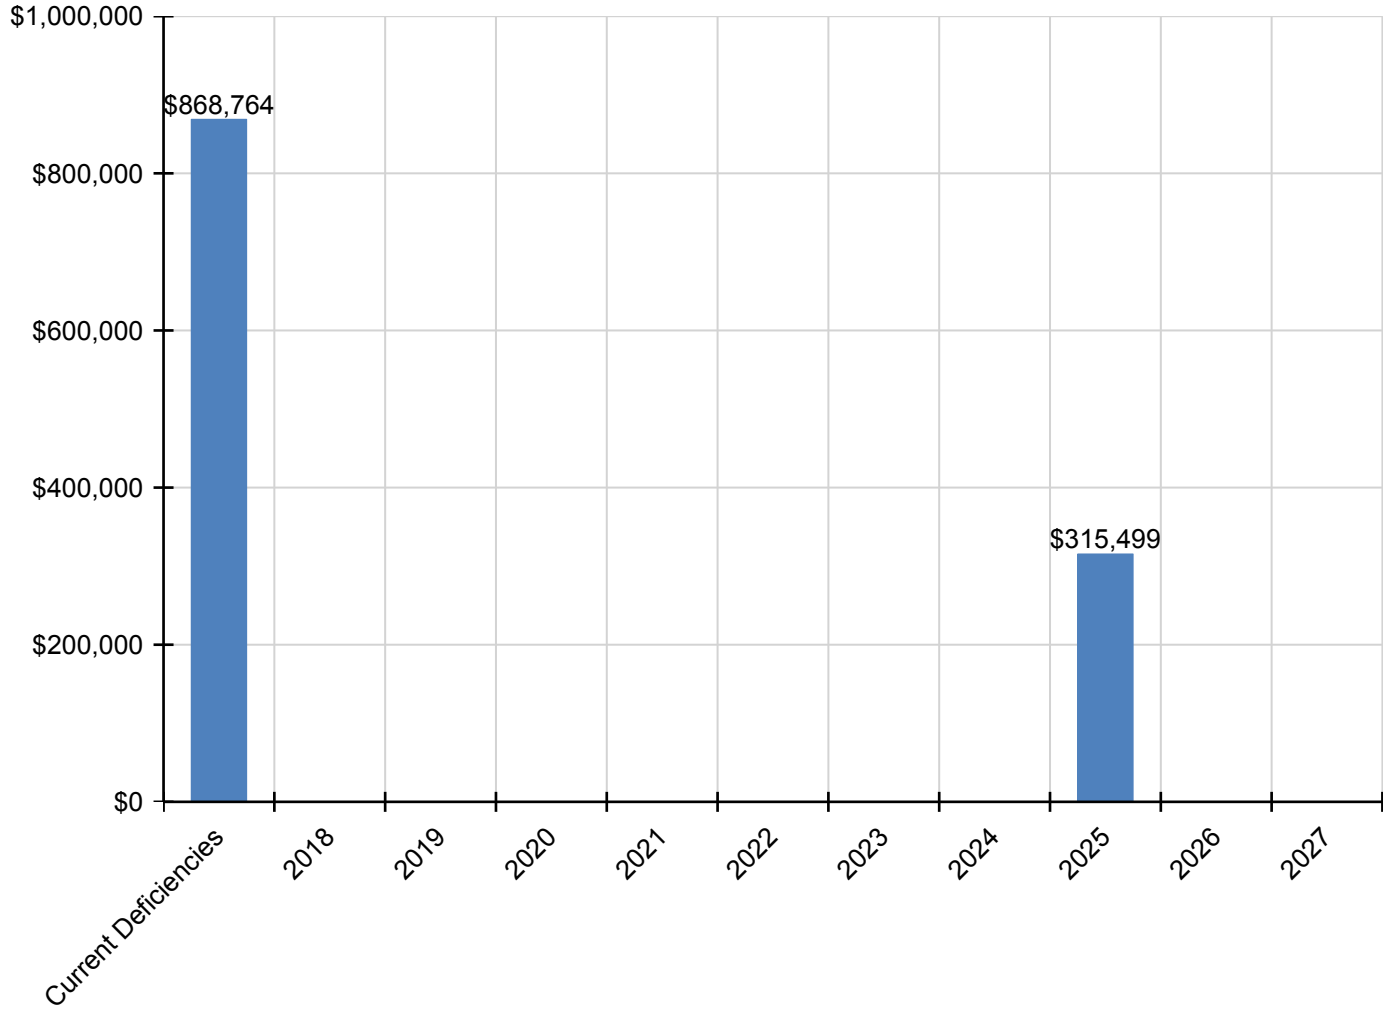
Forecasted Capital Renewal Requirement

The following chart shows the current building deficiencies and forecasting capital renewal or sustainment requirements over the next ten years.

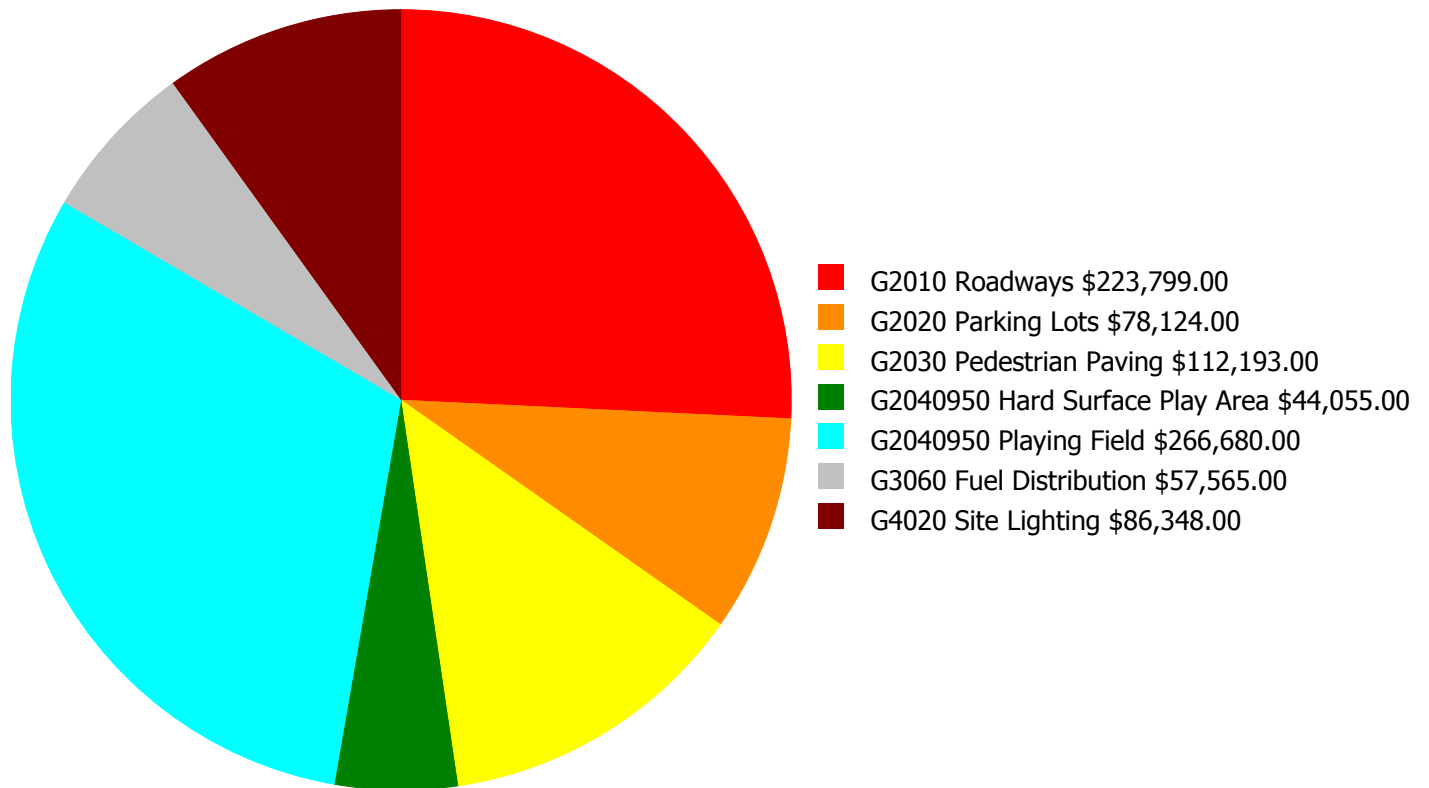
Deficiency Summary by System

Current deficiencies included assemblies that have reached or exceeded their design life or components of the assemblies that are in need of repair. Assemblies that have reached their design life are identified as current deficiencies and assigned the distress 'Beyond Useful Life'. The following chart lists all current deficiencies associated with this facility.

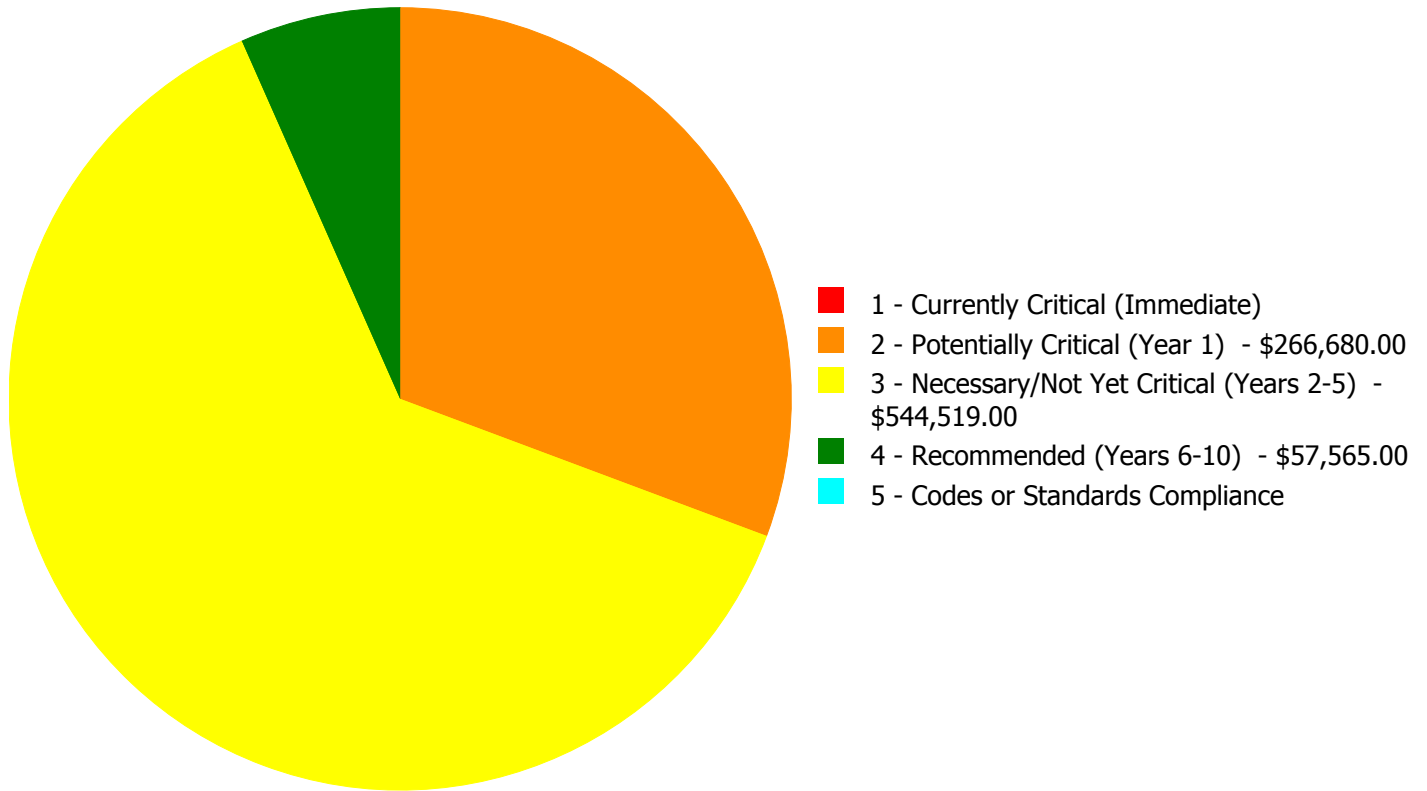
Deficiency Summary by Priority

The following chart shows the total repair costs broken down by priority. Assessors assigned deficiencies within eCOMET to one of the following priority categories:

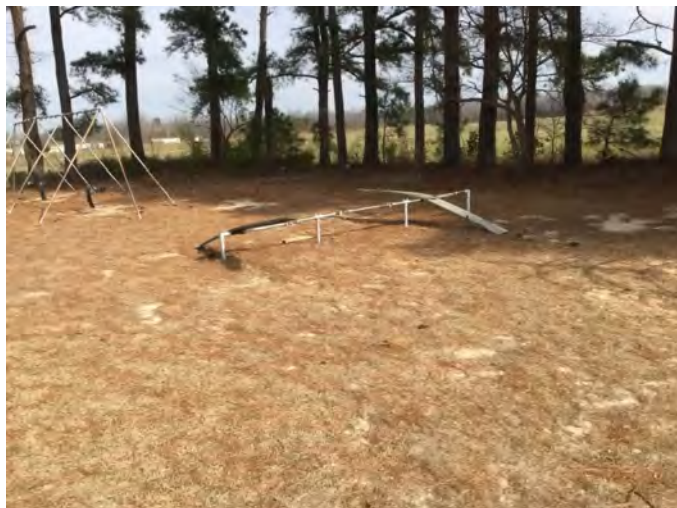
System: G2040950 - Playing Field

Location: Playgrounds
Distress: Beyond Service Life
Category: Deferred Maintenance / Safety
Priority: 2 - Potentially Critical (Year 1)
Correction: Renew System
Qty: 53,400.00
Unit of Measure: S.F.
Estimate: \$266,680.00
Assessor Name: Eduardo Lopez
Date Created: 02/23/2017

Notes: Playground equipment is mostly obsolete. System renewal is recommended.

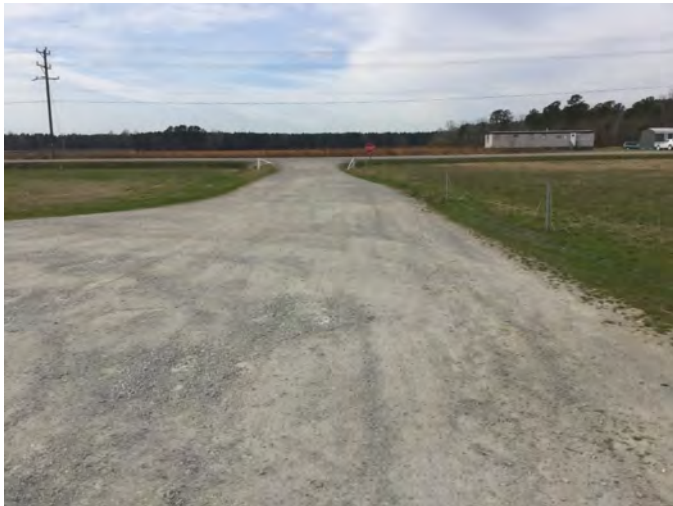
System: G2010 - Roadways

Location: Site
Distress: Beyond Service Life
Category: Deferred Maintenance
Priority: 3 - Necessary/Not Yet Critical (Years 2-5)
Correction: Renew System
Qty: 53,400.00
Unit of Measure: S.F.
Estimate: \$223,799.00
Assessor Name: Eduardo Lopez
Date Created: 02/23/2017

Notes: Roadways are in deteriorated condition with grainy surface, some cracked pavement and potholes. The road to the north parking lot is unpaved. System renewal is recommended.

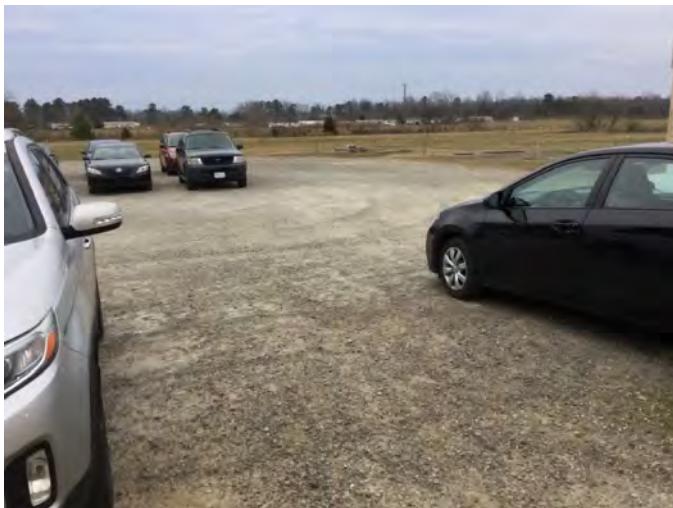
System: G2020 - Parking Lots

Location: North and south lots
Distress: Beyond Service Life
Category: Deferred Maintenance
Priority: 3 - Necessary/Not Yet Critical (Years 2-5)
Correction: Renew System
Qty: 53,400.00
Unit of Measure: S.F.
Estimate: \$78,124.00
Assessor Name: Eduardo Lopez
Date Created: 02/23/2017

Notes: The north parking lot is in very poor condition and is virtually unpaved. The south lot is beginning to deteriorate with a very grainy surface and cracking in asphalt. The south lot has been enlarged without paving the expanded area. Handicap spaces are not properly designated and striping is faded or non-existent throughout the parking lots. System renewal is recommended.

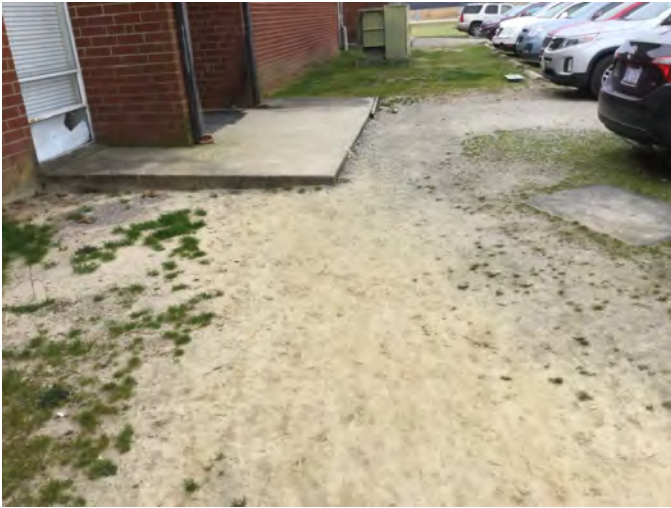
System: G2030 - Pedestrian Paving

Location: Around the site
Distress: Inadequate
Category: Deferred Maintenance / Safety
Priority: 3 - Necessary/Not Yet Critical (Years 2-5)
Correction: Renew System
Qty: 53,400.00
Unit of Measure: S.F.
Estimate: \$112,193.00
Assessor Name: Eduardo Lopez
Date Created: 02/23/2017

Notes: Concrete paving in the courtyard is badly degraded. Paving is missing connecting the parking lot to the building at the north lot. Some cracking, settlement or heaving, and surface wear is occurring along the front of the building. System renewal is recommended..

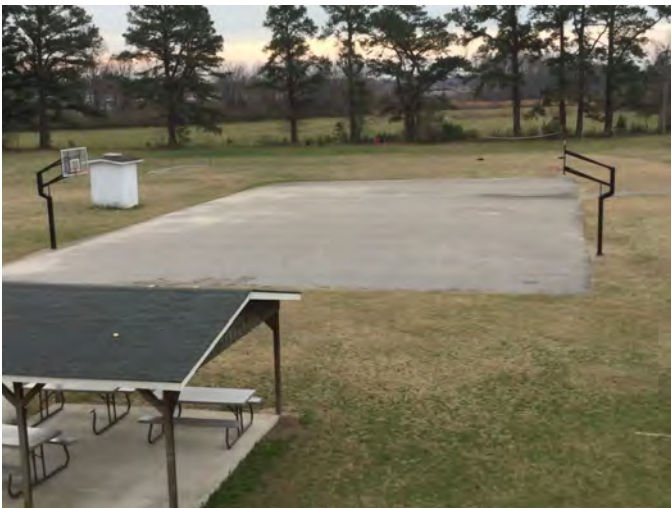
System: G2040950 - Hard Surface Play Area

Location: Site
Distress: Beyond Service Life
Category: Deferred Maintenance
Priority: 3 - Necessary/Not Yet Critical (Years 2-5)
Correction: Renew System
Qty: 53,400.00
Unit of Measure: S.F.
Estimate: \$44,055.00
Assessor Name: Eduardo Lopez
Date Created: 02/23/2017

Notes: The outdoor basketball court surface is degrading. System renewal is recommended.

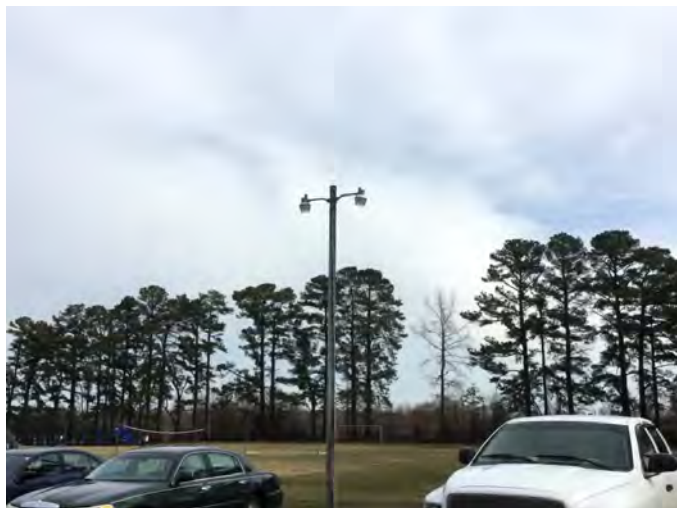
System: G4020 - Site Lighting

Location: Site
Distress: Inadequate
Category: Deferred Maintenance / Safety
Priority: 3 - Necessary/Not Yet Critical (Years 2-5)
Correction: Renew System
Qty: 53,400.00
Unit of Measure: S.F.
Estimate: \$86,348.00
Assessor Name: Eduardo Lopez
Date Created: 02/23/2017

Notes: Site lighting is inadequate with one double headed pole mounted light in the south parking lot, and some building mounted light illuminating areas close to the building. System renewal is recommended.

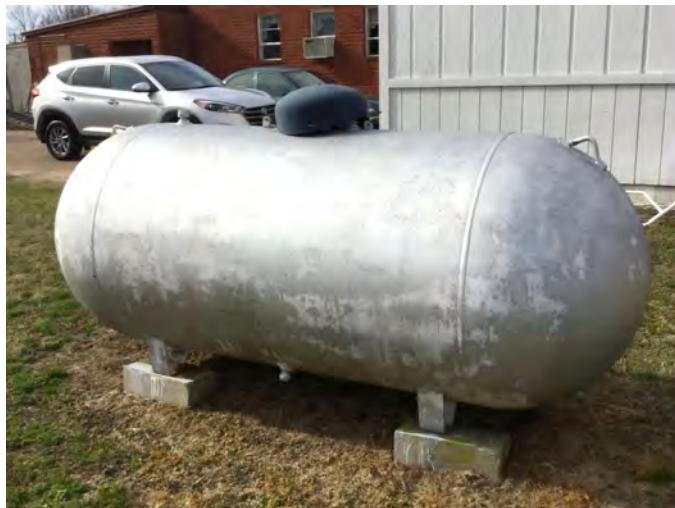
System: G3060 - Fuel Distribution

Location: Site near mechanical room
Distress: Beyond Service Life
Category: Deferred Maintenance
Priority: 4 - Recommended (Years 6-10)
Correction: Renew System
Qty: 53,400.00
Unit of Measure: S.F.
Estimate: \$57,565.00
Assessor Name: Eduardo Lopez
Date Created: 02/23/2017

Notes: While the propane fuel tank and piping has no reported or observed operational problems, it is beyond its expected service life and should be considered for replacement.

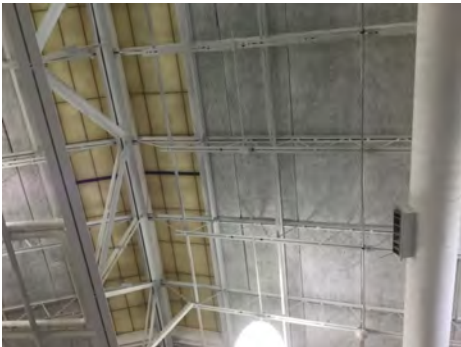
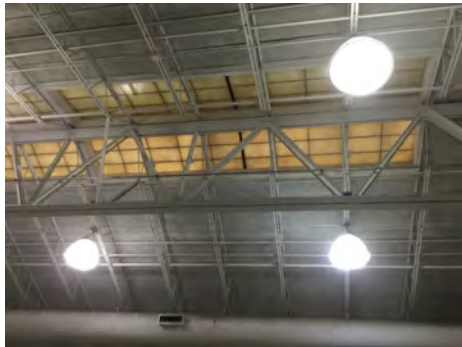
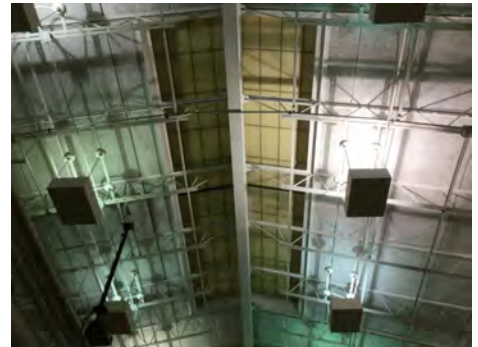
System: B3020 - Roof Openings

Note: Sandwich panel translucent insulated skylight assemblies were inspected at time of re-roofing. System renewal date pushed 10 years from shingle replacement.

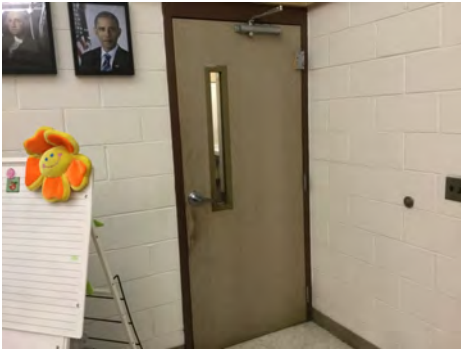
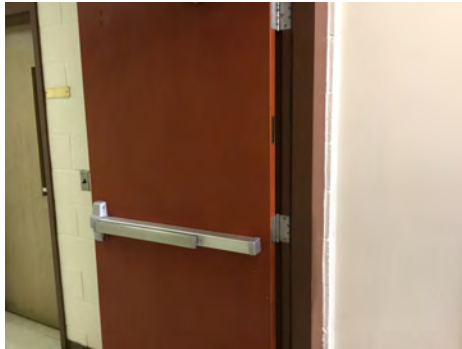
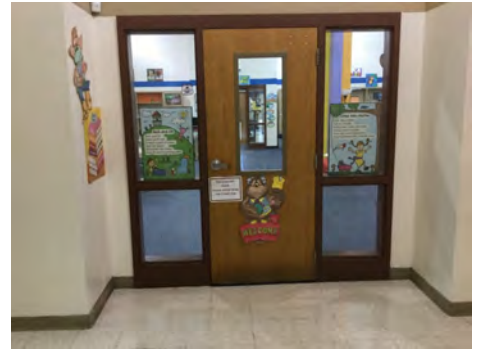
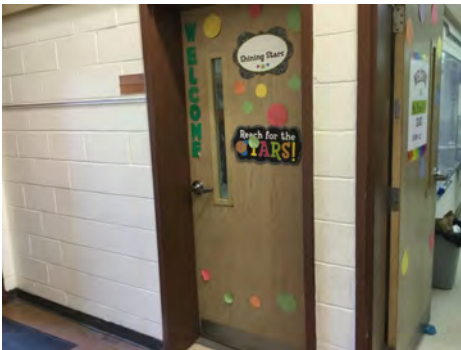
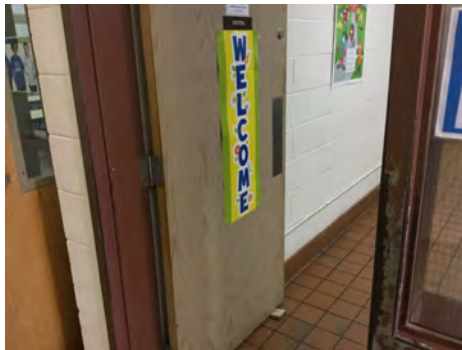
System: C1020 - Interior Doors

Note: Interior and exterior door locks and re-keying done 2016. Doors and frames need to be refinished.

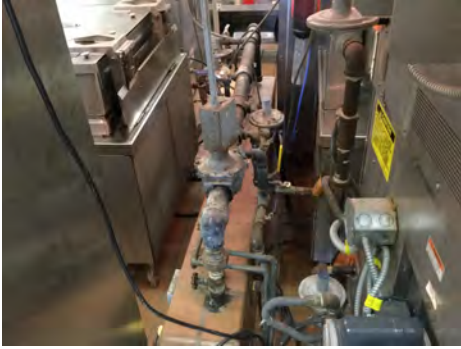
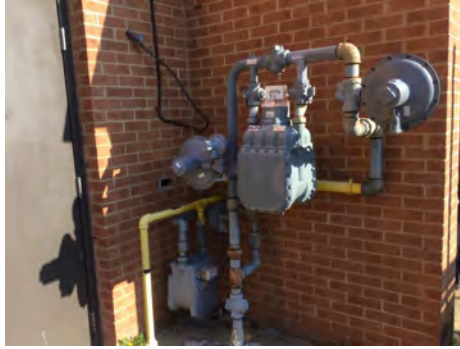
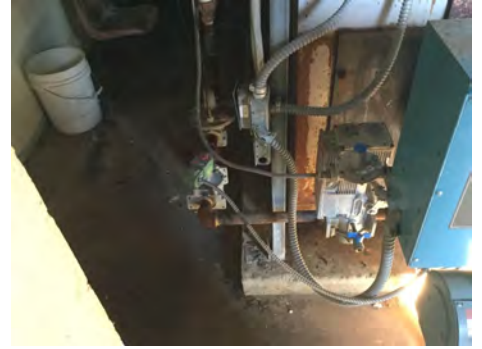
System: D2090 - Other Plumbing Systems -Nat Gas

Note: Fuel supply changed from oil to natural gas 5 years ago. Fuel oil tank abandoned in place.

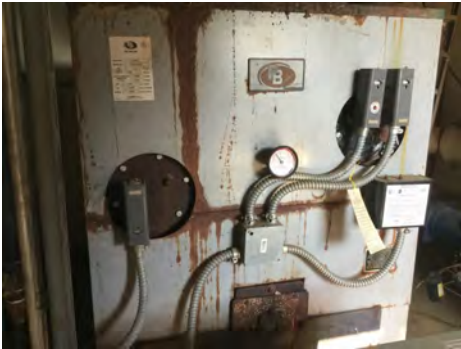
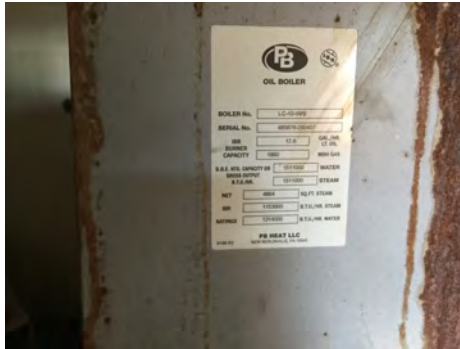
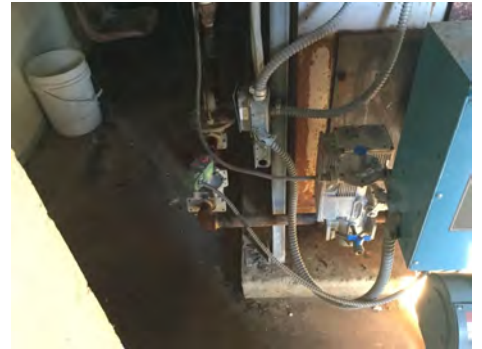
System: D3020 - Heat Generating Systems

Note: Burner converted from fuel oil to natural gas 5 years ago..

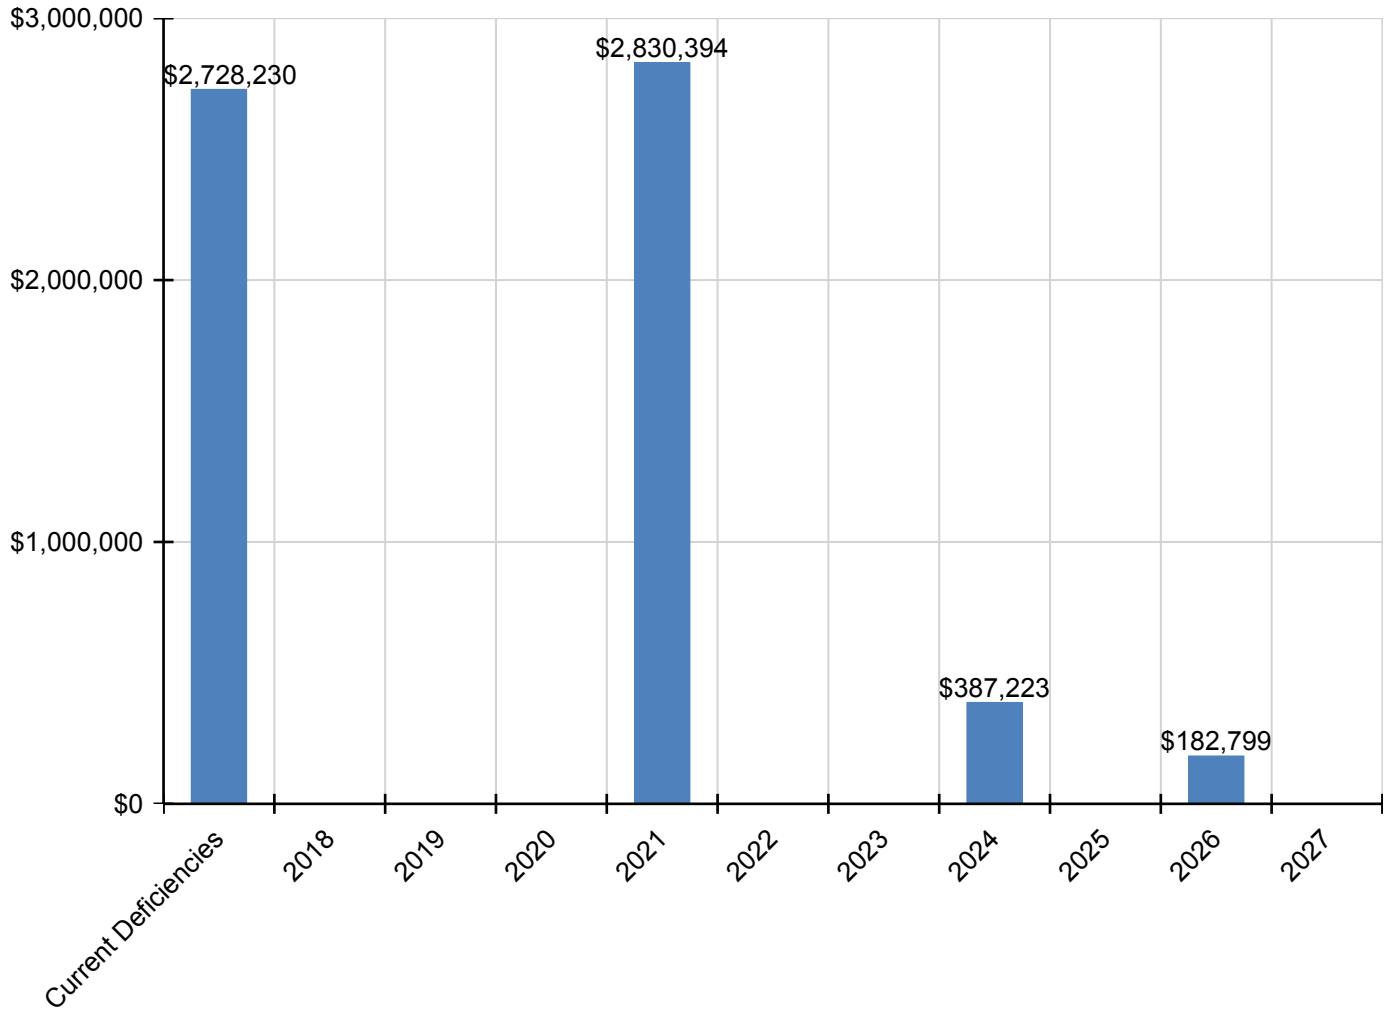
Forecasted Capital Renewal Requirement

The following chart shows the current building deficiencies and forecasting capital renewal or sustainment requirements over the next ten years.

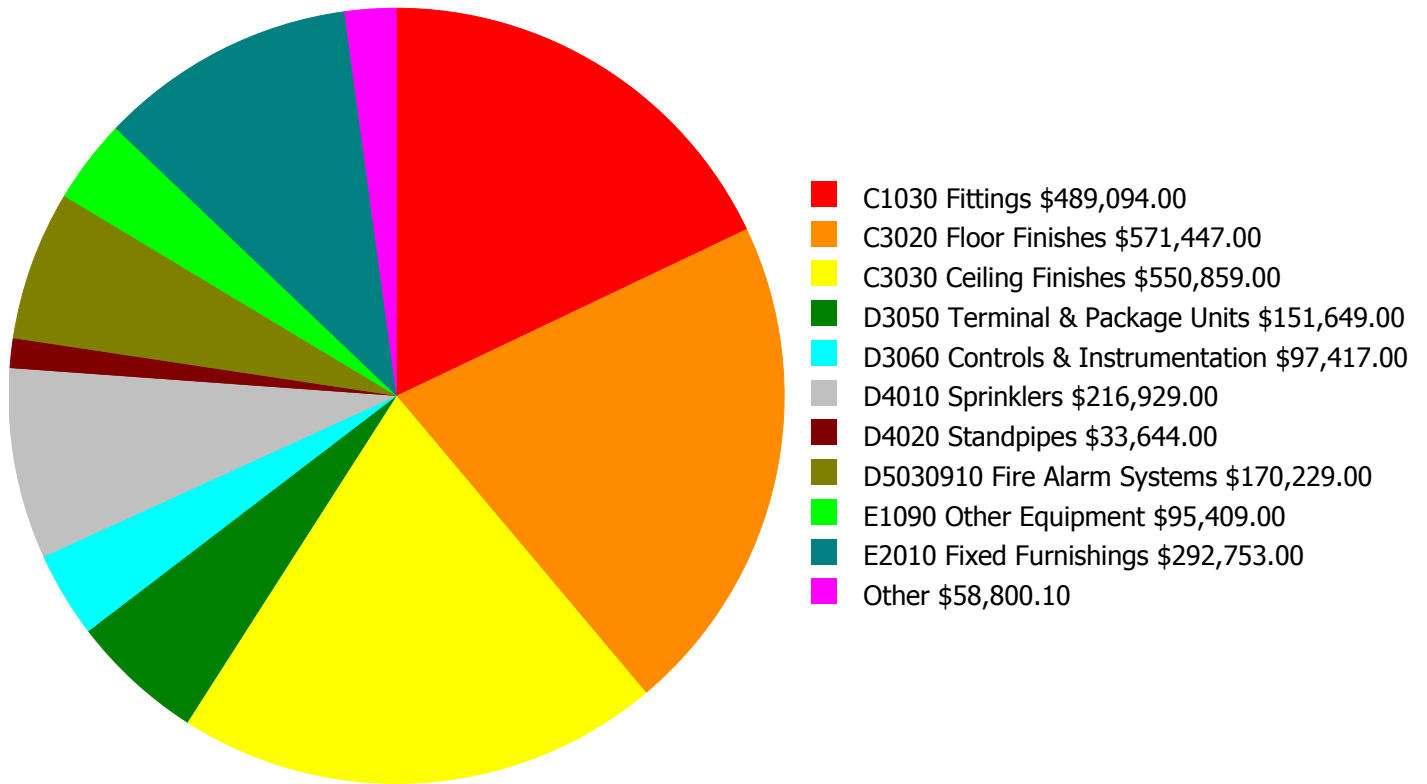
Deficiency Summary by System

Current deficiencies included assemblies that have reached or exceeded their design life or components of the assemblies that are in need of repair. Assemblies that have reached their design life are identified as current deficiencies and assigned the distress 'Beyond Useful Life'. The following chart lists all current deficiencies associated with this facility.

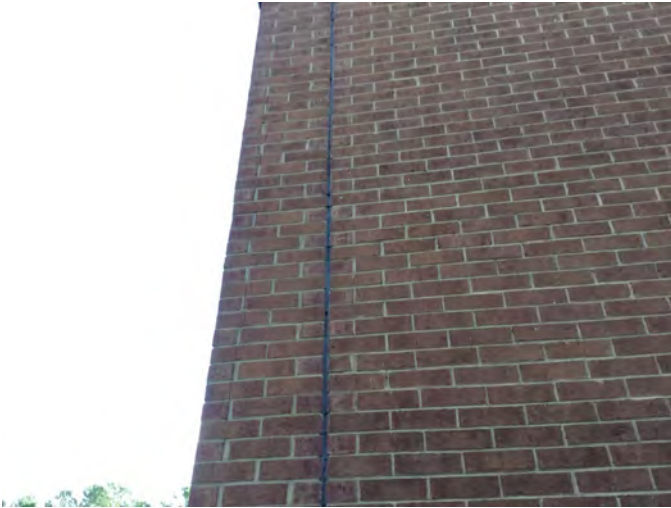
System: B2010 - Exterior Walls

Location: Around the building
Distress: Failing
Category: Deferred Maintenance
Priority: 3 - Necessary/Not Yet Critical (Years 2-5)
Correction: Recaulk expansion and control joints
Qty: 500.00
Unit of Measure: L.F.
Estimate: \$18,711.00
Assessor Name: Somnath Das
Date Created: 02/16/2017

Notes: Masonry caulk joints are dried, cracked and/or missing, particularly noted at north end of building. Some brick cracking observed. It does not appear to be structural, but should be repaired.

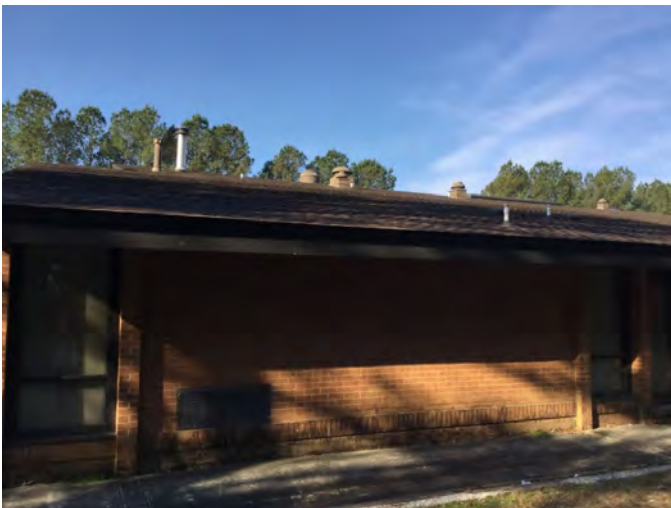
System: B3010140 - Asphalt Shingles

Location: Roof eaves
Distress: Inadequate
Category: Deferred Maintenance
Priority: 3 - Necessary/Not Yet Critical (Years 2-5)
Correction: Replace / Install Gutters and Downspouts
Qty: 700.00
Unit of Measure: L.F.
Estimate: \$11,804.10
Assessor Name: Somnath Das
Date Created: 02/16/2017

Notes: Gutters and downspouts are not installed at roof eave edges. Most eave edges are located over sidewalks and the runoff causes premature wearing of concrete and hazardous conditions in freezing weather. Installation of gutters and downspouts is recommended.

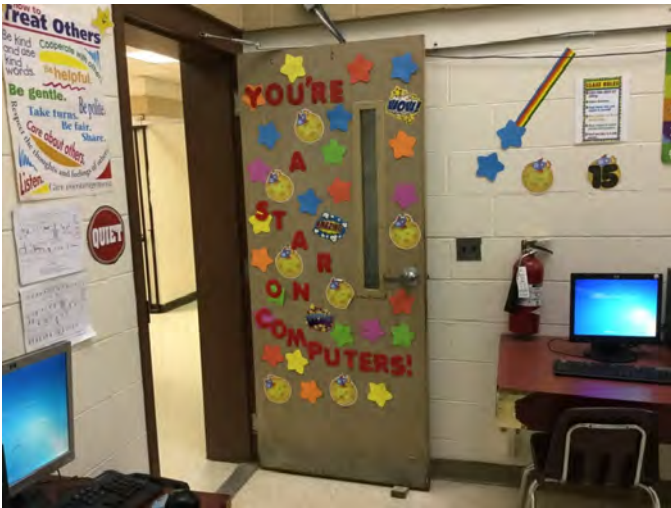
System: C1020 - Interior Doors

Location: Interior doors
Distress: Damaged
Category: Deferred Maintenance / Appearance
Priority: 3 - Necessary/Not Yet Critical (Years 2-5)
Correction: Refinish 3'-0" x 7'-0" solid core wood door, interior
Qty: 50.00
Unit of Measure: Ea.
Estimate: \$7,194.00
Assessor Name: Somnath Das
Date Created: 02/16/2017

Notes: Interior doors have had new lever locks installed and been re-keyed in 2016. Door and frame refinishing is recommended as they are worn.

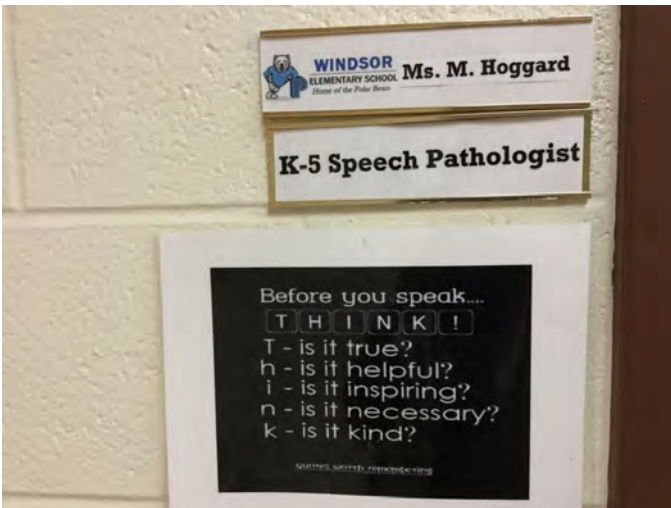
System: C1030 - Fittings

Location: Throughout the building
Distress: Beyond Service Life
Category: Deferred Maintenance
Priority: 3 - Necessary/Not Yet Critical (Years 2-5)
Correction: Renew System
Qty: 45,650.00
Unit of Measure: S.F.
Estimate: \$489,094.00
Assessor Name: Somnath Das
Date Created: 02/16/2017

Notes: Fittings are generally beyond their expected service life. Signage is not up to code. Some blackboards are in the building. Whiteboards are stained beyond leaning. Kitchen lockers are rusted. System renewal is recommended.

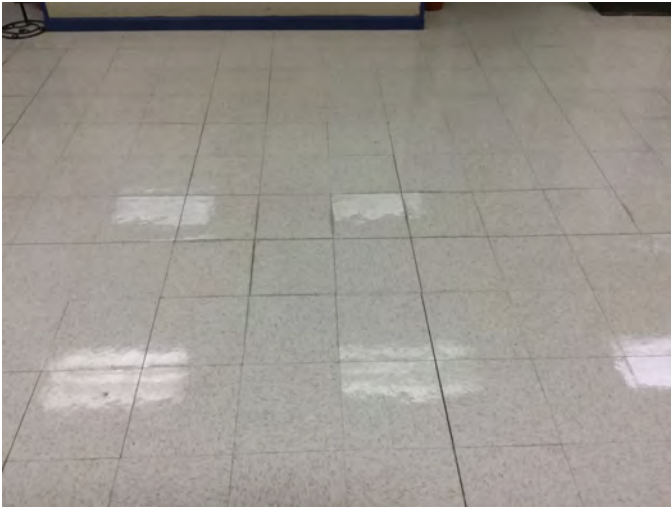
System: C3020 - Floor Finishes

Location: Throughout the building
Distress: Beyond Service Life
Category: Deferred Maintenance
Priority: 3 - Necessary/Not Yet Critical (Years 2-5)
Correction: Renew System
Qty: 45,650.00
Unit of Measure: S.F.
Estimate: \$571,447.00
Assessor Name: Somnath Das
Date Created: 02/16/2017

Notes: Floor finishes were changed from carpet to VCT in corridors and most classrooms about 10 years ago. The installation was made without proper floor prep and there are many lumps and bumps visible telegraphing through the tile. Many joints are open. Glue comes up between joints. System renewal is recommended.

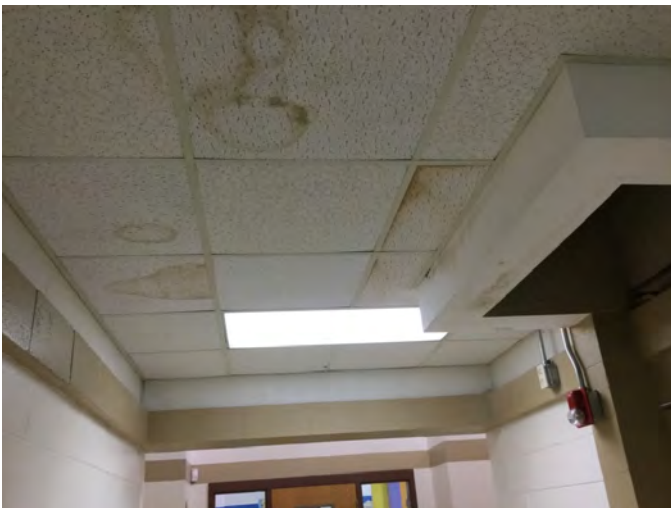
System: C3030 - Ceiling Finishes

Location: Throughout the building
Distress: Beyond Service Life
Category: Deferred Maintenance
Priority: 3 - Necessary/Not Yet Critical (Years 2-5)
Correction: Renew System
Qty: 45,650.00
Unit of Measure: S.F.
Estimate: \$550,859.00
Assessor Name: Somnath Das
Date Created: 02/16/2017

Notes: Ceiling finishes are typically original and beyond their expected useful life. Many water stained tile were observed during assessment. System renewal is recommended.

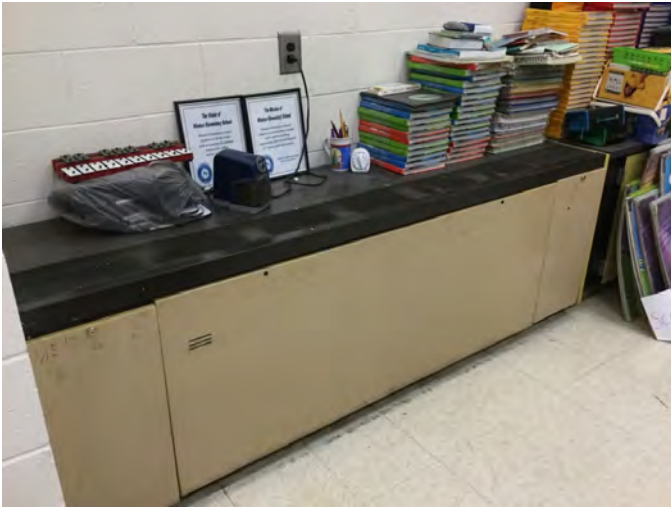
System: D3050 - Terminal & Package Units

Location: Throughout the building
Distress: Beyond Service Life
Category: Deferred Maintenance
Priority: 3 - Necessary/Not Yet Critical (Years 2-5)
Correction: Renew System
Qty: 45,650.00
Unit of Measure: S.F.
Estimate: \$151,649.00
Assessor Name: Somnath Das
Date Created: 02/16/2017

Notes: Terminal and package units are typically original and beyond their expected service life. Classroom unit ventilators are noisy and fresh air dampers do not work properly so outside air intakes are covered in winter. System renewal is recommended.
