NC School District/080 Bertie County/Middle School

Bertie Middle

Campus Assessment Report

March 8, 2017

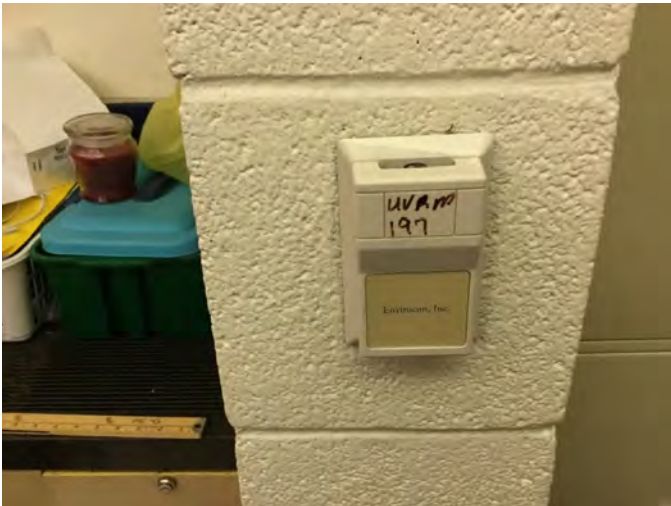
System: D3060 - Controls & Instrumentation

Location: Throughout the building
Distress: Beyond Service Life
Category: Deferred Maintenance
Priority: 3 - Necessary/Not Yet Critical (Years 2-5)
Correction: Renew System
Qty: 45,650.00
Unit of Measure: S.F.
Estimate: \$97,417.00
Assessor Name: Somnath Das
Date Created: 02/16/2017

Notes: Digital controls are original and beyond their service life. They are locally controlled. Installation of a modern digital system with remote monitoring and control capability for energy conservation is recommended.

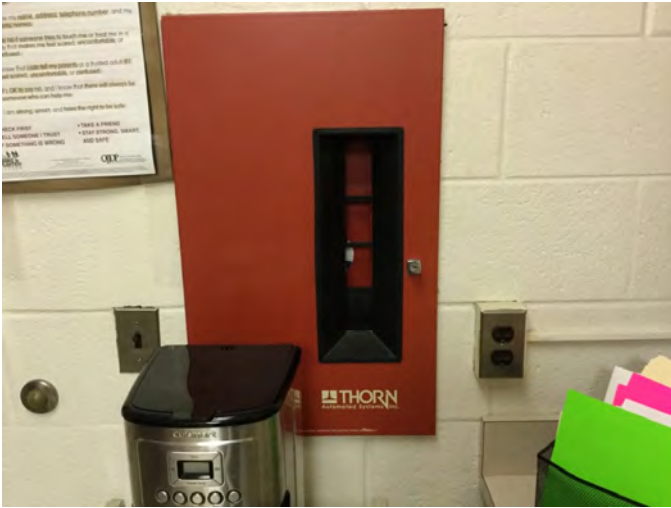
System: D5030910 - Fire Alarm Systems

Location: Throughout the building
Distress: Beyond Service Life
Category: Deferred Maintenance / Life Safety Code Compliance
Priority: 3 - Necessary/Not Yet Critical (Years 2-5)
Correction: Renew System
Qty: 45,650.00
Unit of Measure: S.F.
Estimate: \$170,229.00
Assessor Name: Somnath Das
Date Created: 02/16/2017

Notes: The fire alarm system is original and beyond its expected life. System renewal is recommended to ensure reliability of this life safety system.

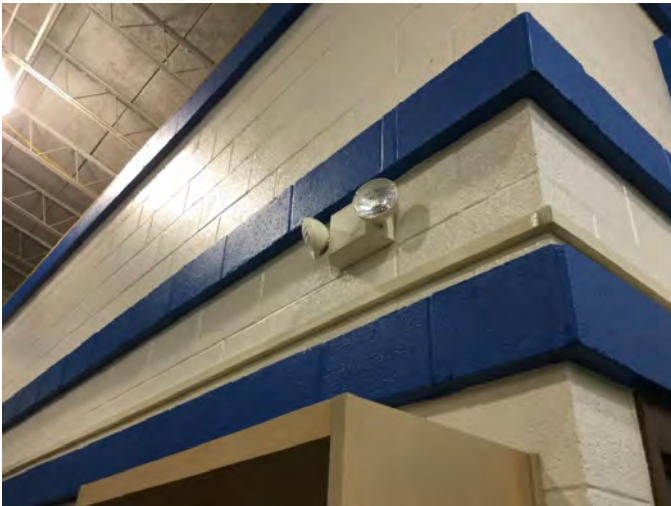
System: D5090 - Other Electrical Systems

Location: Throughout the building
Distress: Beyond Service Life
Category: Deferred Maintenance / Life Safety Code Compliance
Priority: 3 - Necessary/Not Yet Critical (Years 2-5)
Correction: Renew System
Qty: 45,650.00
Unit of Measure: S.F.
Estimate: \$6,026.00
Assessor Name: Somnath Das
Date Created: 02/16/2017

Notes: Emergency lighting is original and beyond its expected life. System renewal of this life safety system is recommended.

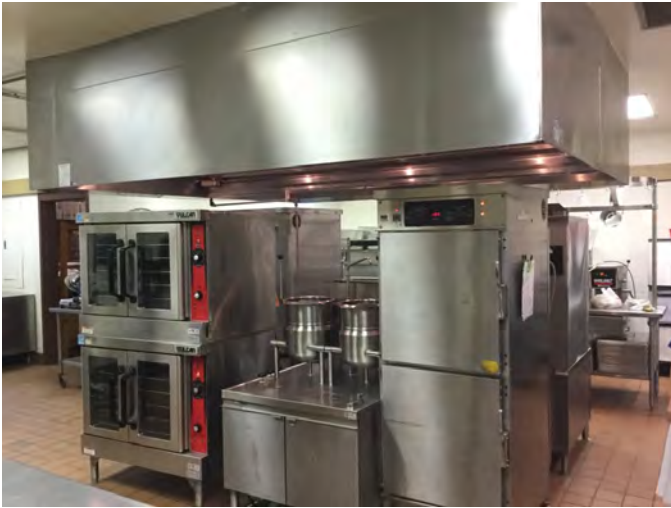
System: E1090 - Other Equipment

Location: Kitchen
Distress: Beyond Service Life
Category: Deferred Maintenance
Priority: 3 - Necessary/Not Yet Critical (Years 2-5)
Correction: Renew System
Qty: 45,650.00
Unit of Measure: S.F.
Estimate: \$95,409.00
Assessor Name: Somnath Das
Date Created: 02/16/2017

Notes: Kitchen equipment is mostly original and beyond its expected useful life. Equipment retrofitted for natural gas operation approx. 5 years ago. System renewal is recommended.

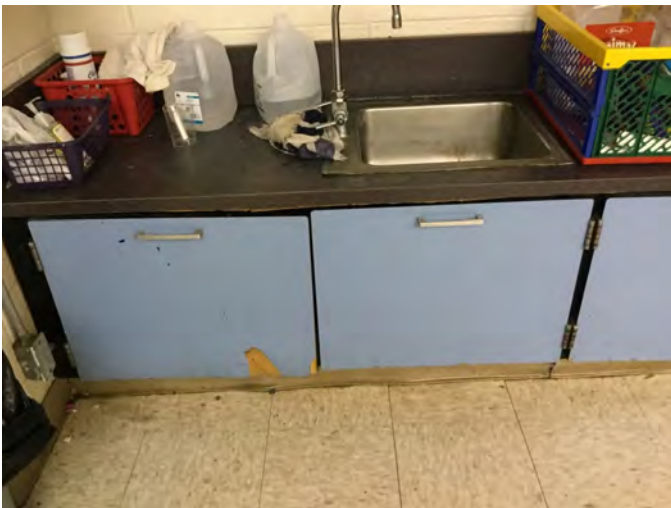
System: E2010 - Fixed Furnishings

Location: Throughout the building
Distress: Beyond Service Life
Category: Deferred Maintenance
Priority: 3 - Necessary/Not Yet Critical (Years 2-5)
Correction: Renew System
Qty: 45,650.00
Unit of Measure: S.F.
Estimate: \$292,753.00
Assessor Name: Somnath Das
Date Created: 02/16/2017

Notes: Fixed furnishing are typically original and in fair to poor condition with chipped laminates, sagging doors, and missing drawers. System renewal is recommended.

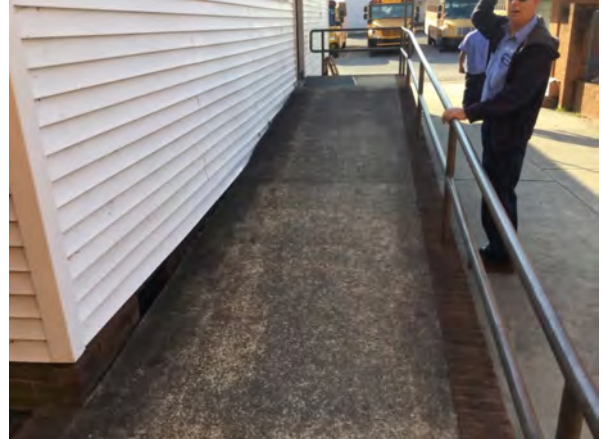
This building was originally constructed to house classrooms for special education. It was determined that those students should be mainstreamed into the regular classrooms and/or housed in the main building. This building is not fully ADA compliant, and is being used mostly for storage.

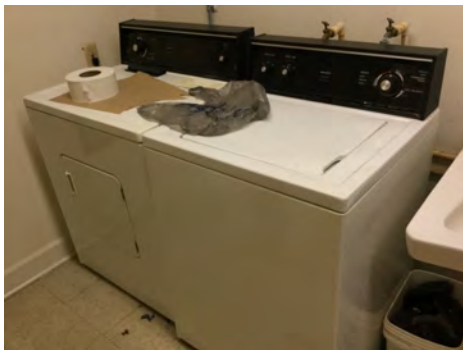
System: E1090 - Other Equipment

Note: Laundry appliances appear to be in good condition and have not been heavily used.

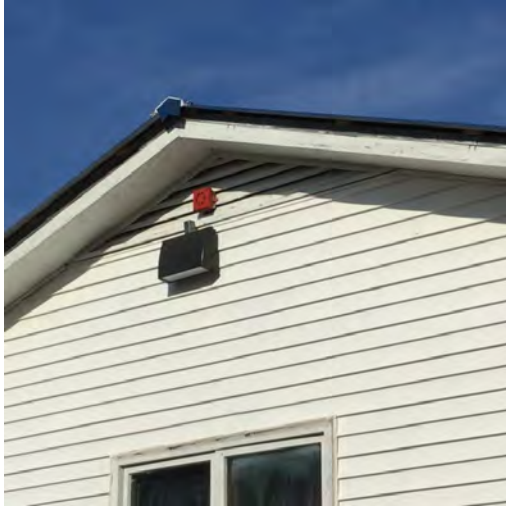
System: D5030910 - Fire Alarm Systems

Location: Throughout the building
Distress: Missing
Category: Life Safety Code Compliance
Priority: 2 - Potentially Critical (Year 1)
Correction: Renew System
Qty: 960.00
Unit of Measure: S.F.
Estimate: \$3,580.00
Assessor Name: Eduardo Lopez
Date Created: 02/22/2017

Notes: The only fire alarm device seen in this building was the outdoor fire bell. Installation of a code compliant fire alarm system including audio/visual annunciators, pull stations, and smoke detectors is recommended.

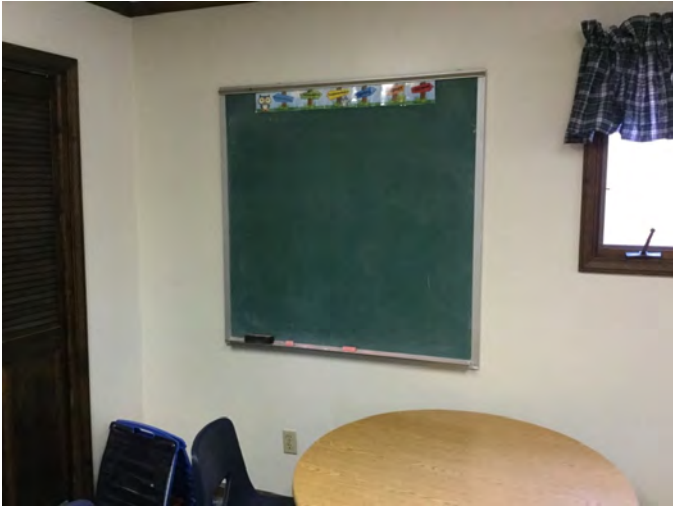
System: C1030 - Fittings

Location: Classroom and toilet room
Distress: Beyond Service Life
Category: Deferred Maintenance
Priority: 3 - Necessary/Not Yet Critical (Years 2-5)
Correction: Renew System
Qty: 960.00
Unit of Measure: S.F.
Estimate: \$10,285.00
Assessor Name: Eduardo Lopez
Date Created: 02/22/2017

Notes: Fittings are out of date. The restroom is not ADA code compliant. Room/building signage is missing.

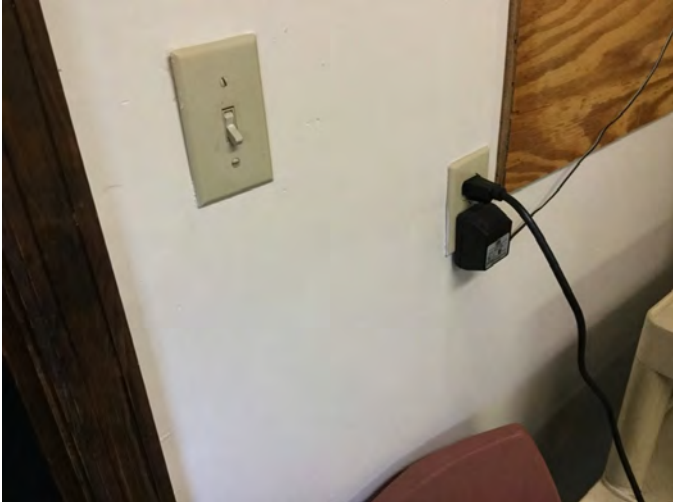
System: C3010 - Wall Finishes

Location: Throughout the building
Distress: Beyond Service Life
Category: Deferred Maintenance
Priority: 3 - Necessary/Not Yet Critical (Years 2-5)
Correction: Renew System
Qty: 960.00
Unit of Measure: S.F.
Estimate: \$2,946.00
Assessor Name: Eduardo Lopez
Date Created: 02/22/2017

Notes: While wall finishes currently are in fair to good condition, other recommended system replacements will result in the need to refresh the wall finishes.

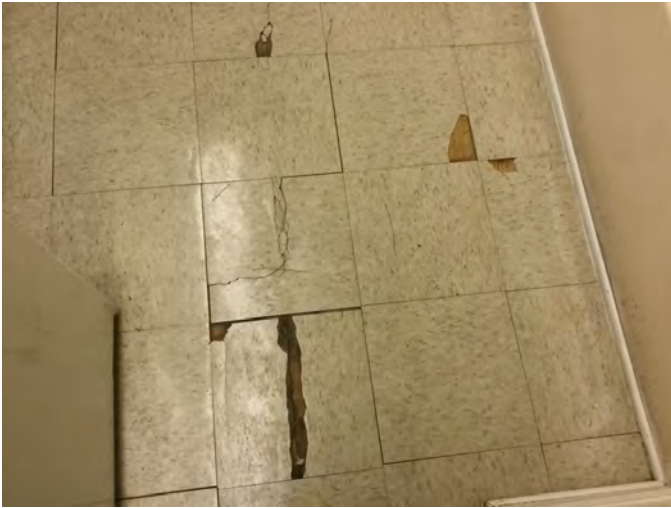
System: C3020 - Floor Finishes

Location: Throughout the building
Distress: Beyond Service Life
Category: Deferred Maintenance
Priority: 3 - Necessary/Not Yet Critical (Years 2-5)
Correction: Renew System
Qty: 960.00
Unit of Measure: S.F.
Estimate: \$12,017.00
Assessor Name: Eduardo Lopez
Date Created: 02/22/2017

Notes: Floor finishes are in fair to poor condition. System renewal is recommended.

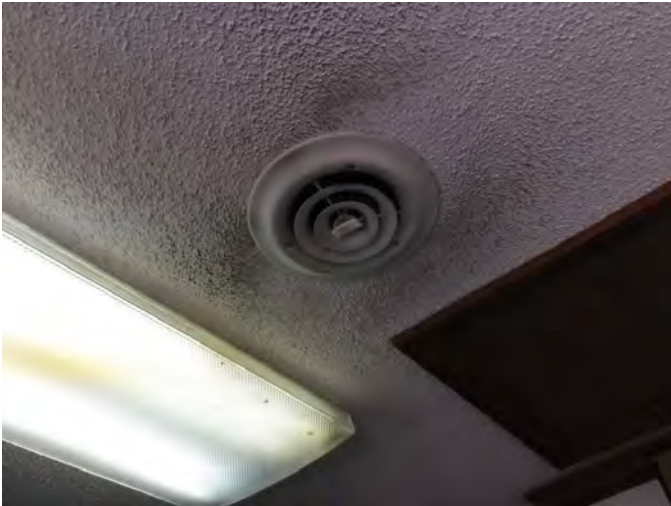
System: C3030 - Ceiling Finishes

Location: Throughout the bulding
Distress: Beyond Service Life
Category: Deferred Maintenance
Priority: 3 - Necessary/Not Yet Critical (Years 2-5)
Correction: Renew System
Qty: 960.00
Unit of Measure: S.F.
Estimate: \$11,584.00
Assessor Name: Eduardo Lopez
Date Created: 02/22/2017

Notes: Ceiling finishes are stained. System renewal is recommended if the building were to be re-occupied.

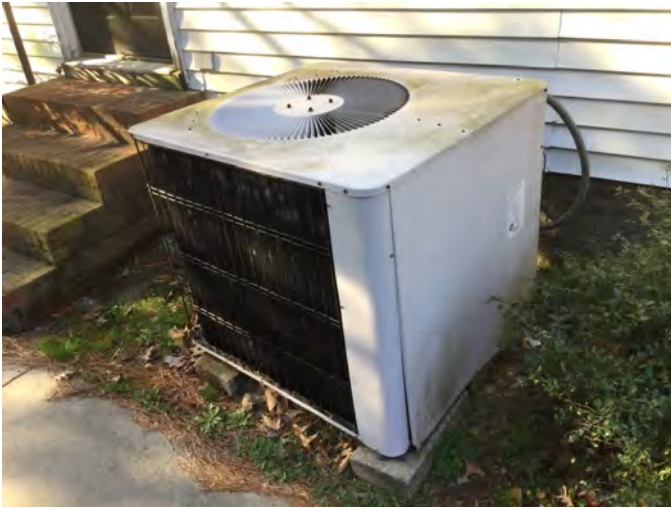
System: D3050 - Terminal & Package Units

Location: Ground mount heat pump
Distress: Beyond Service Life
Category: Deferred Maintenance
Priority: 3 - Necessary/Not Yet Critical (Years 2-5)
Correction: Renew System
Qty: 960.00
Unit of Measure: S.F.
Estimate: \$20,603.00
Assessor Name: Eduardo Lopez
Date Created: 02/22/2017

Notes: The heat pump is beyond its expected useful life. Replacement with an energy efficient model is recommended.

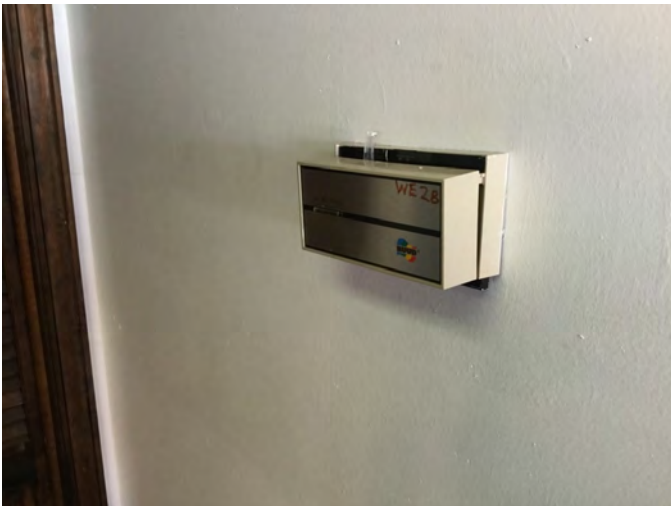
System: D3060 - Controls & Instrumentation

Location: Throughout the bulding
Distress: Beyond Service Life
Category: Deferred Maintenance
Priority: 3 - Necessary/Not Yet Critical (Years 2-5)
Correction: Renew System
Qty: 960.00
Unit of Measure: S.F.
Estimate: \$2,049.00
Assessor Name: Eduardo Lopez
Date Created: 02/22/2017

Notes: Building controls are typically original. They are locally controlled. Installation of a modern digital system with remote monitoring and control capability for energy conservation is recommended.

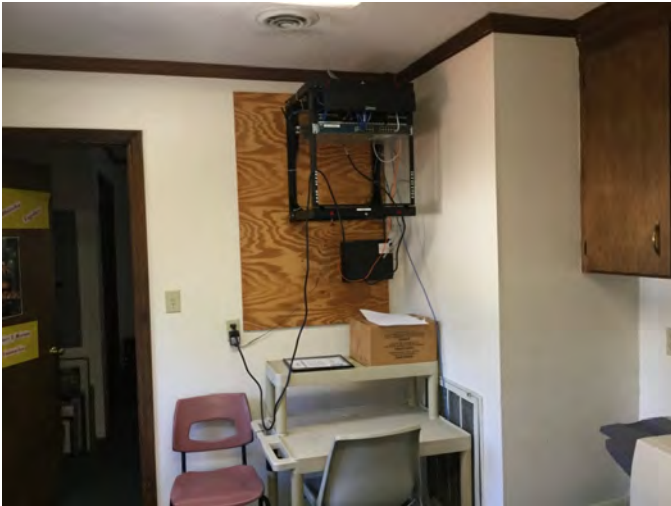
System: D5030920 - Data Communication

Location: Throughout the building
Distress: Beyond Service Life
Category: Deferred Maintenance
Priority: 3 - Necessary/Not Yet Critical (Years 2-5)
Correction: Renew System
Qty: 960.00
Unit of Measure: S.F.
Estimate: \$4,646.00
Assessor Name: Eduardo Lopez
Date Created: 02/22/2017

Notes: Updating of data and communications equipment is recommended if the building were to be re-occupied.

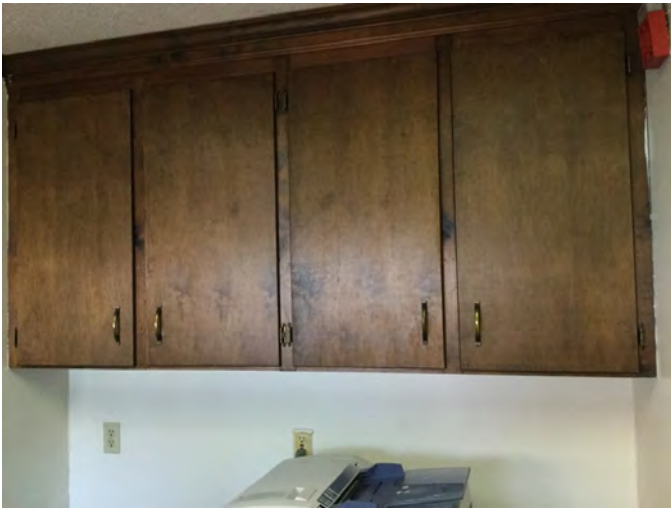
System: E2010 - Fixed Furnishings

Location: Workroom
Distress: Beyond Service Life
Category: Deferred Maintenance
Priority: 4 - Recommended (Years 6-10)
Correction: Renew System
Qty: 960.00
Unit of Measure: S.F.
Estimate: \$6,156.00
Assessor Name: Eduardo Lopez
Date Created: 02/22/2017

Notes: Fixed furnishings are beyond their expected life. System renewal is recommended.

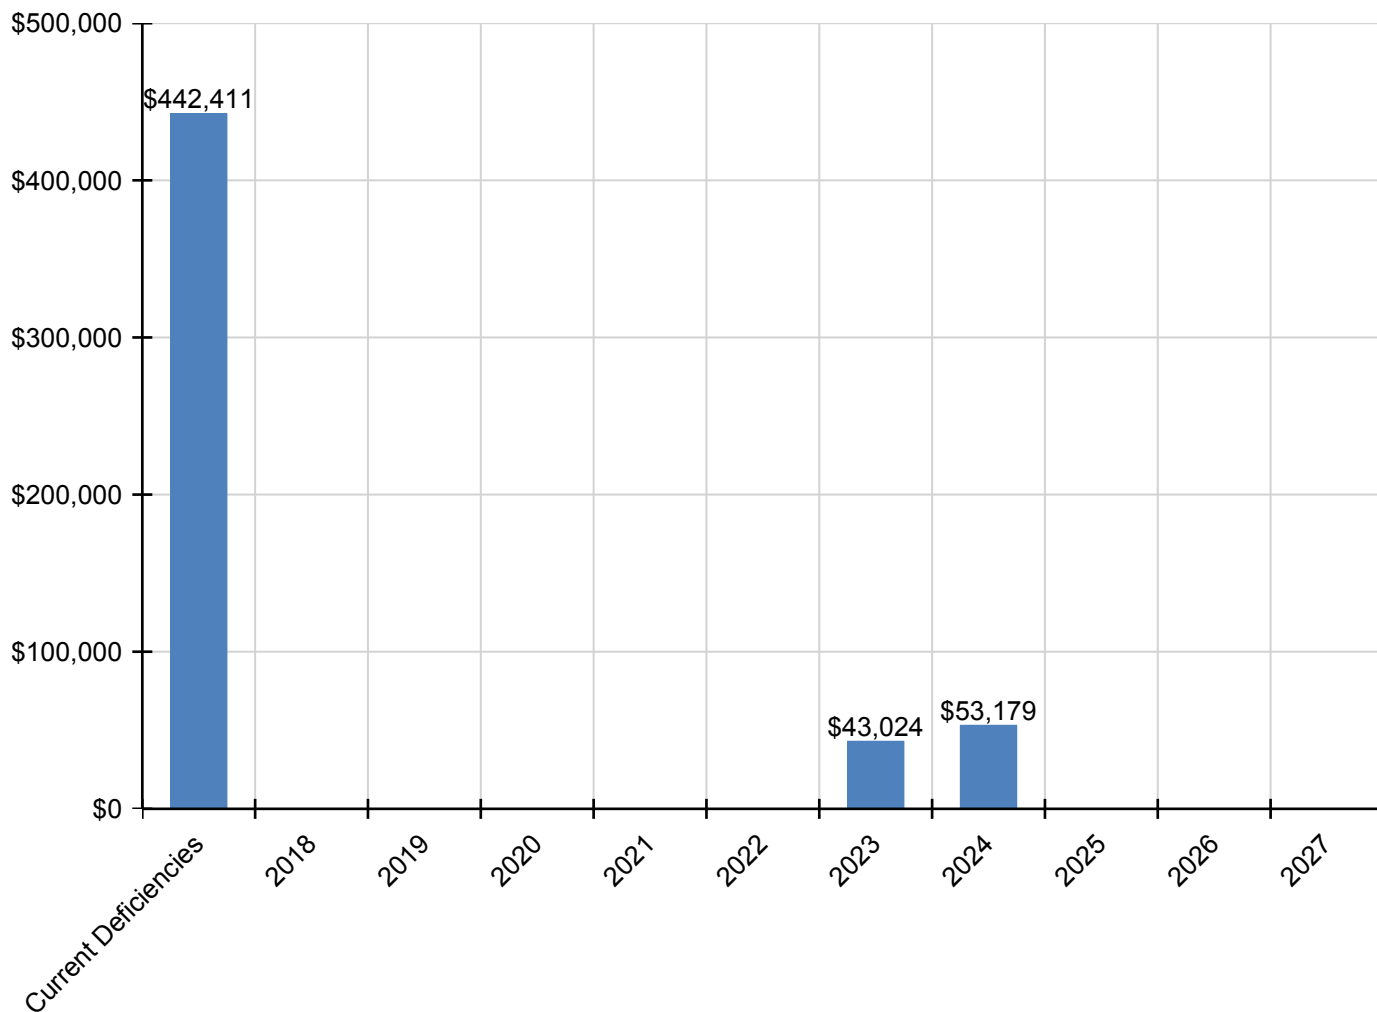
Forecasted Capital Renewal Requirement

The following chart shows the current building deficiencies and forecasting capital renewal or sustainment requirements over the next ten years.

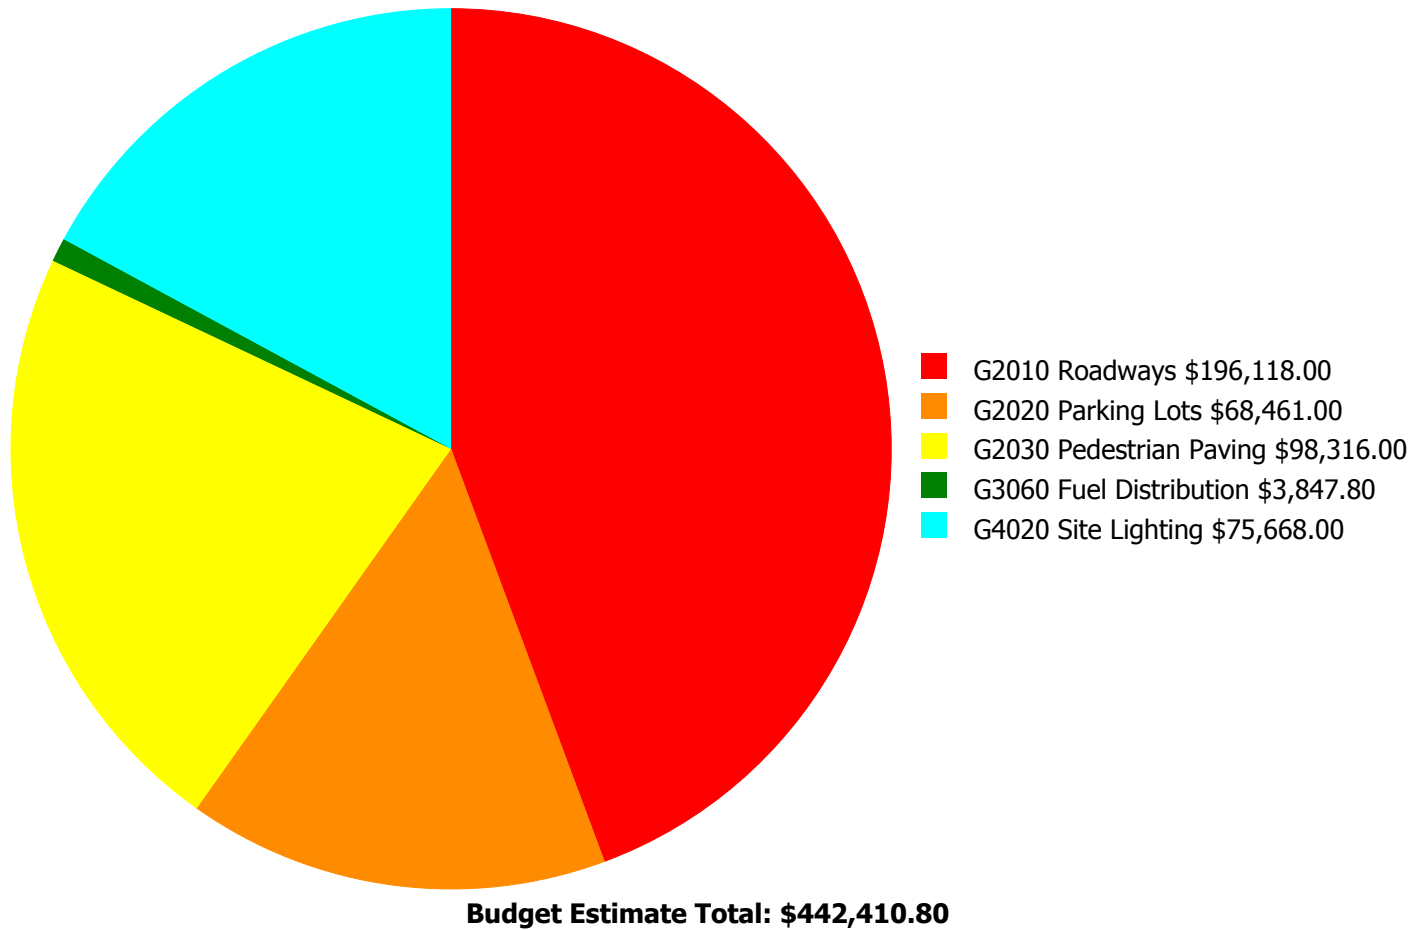
Deficiency Summary by System

Current deficiencies included assemblies that have reached or exceeded their design life or components of the assemblies that are in need of repair. Assemblies that have reached their design life are identified as current deficiencies and assigned the distress 'Beyond Useful Life'. The following chart lists all current deficiencies associated with this facility.

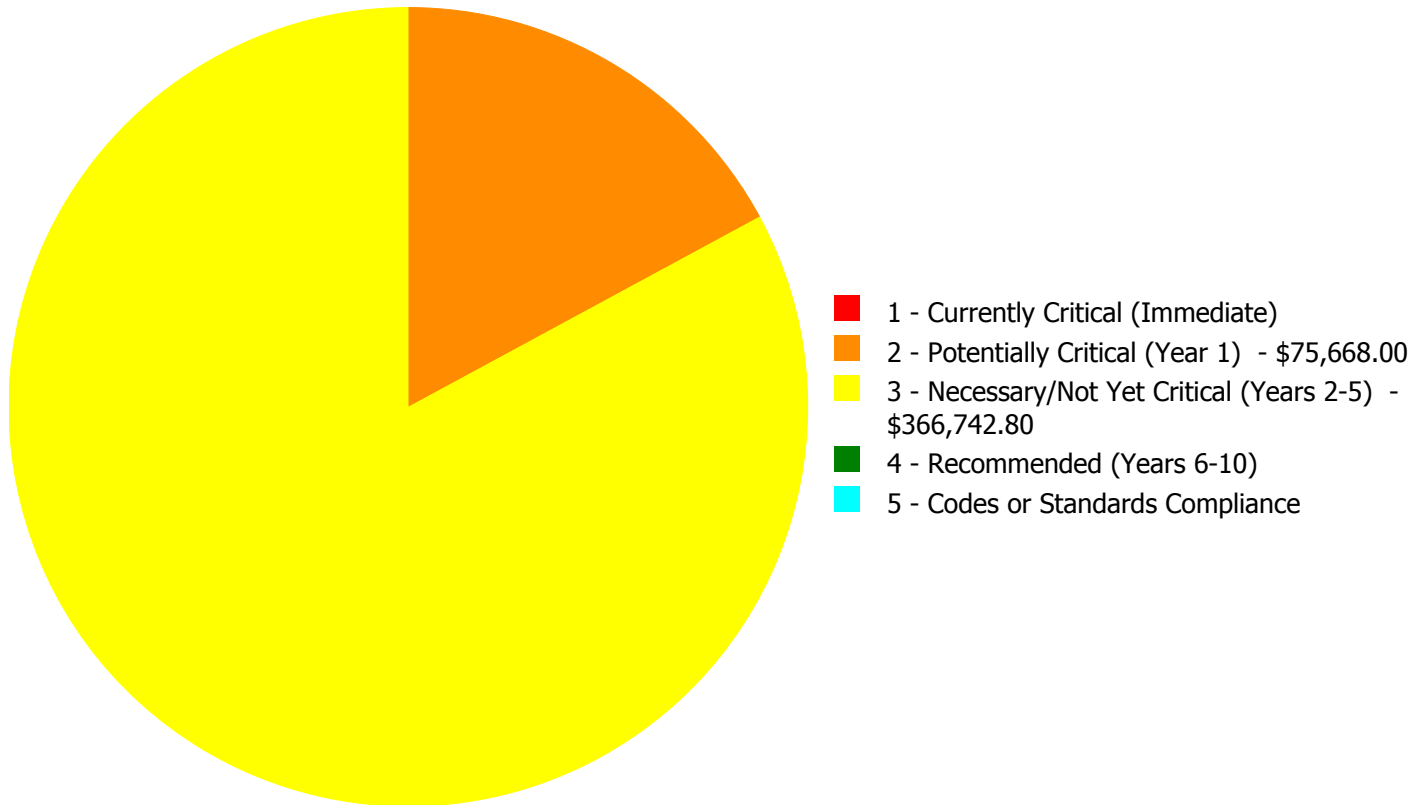
Deficiency Summary by Priority

The following chart shows the total repair costs broken down by priority. Assessors assigned deficiencies within eCOMET to one of the following priority categories:

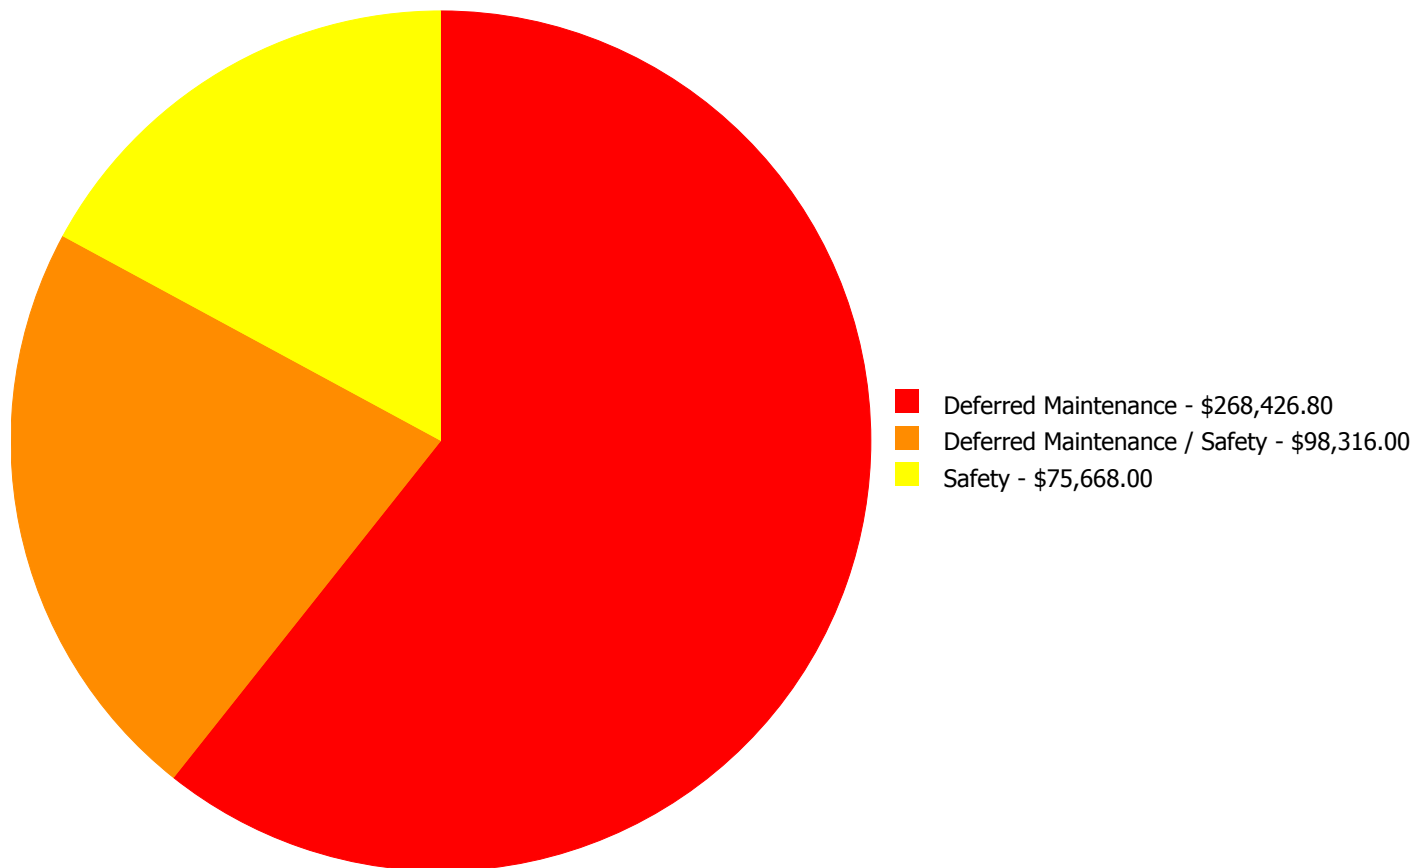
Deficiency Summary by Category

The following chart shows the total repair costs broken down by deficiency categories. Assessors assigned deficiencies to one of the following categories:

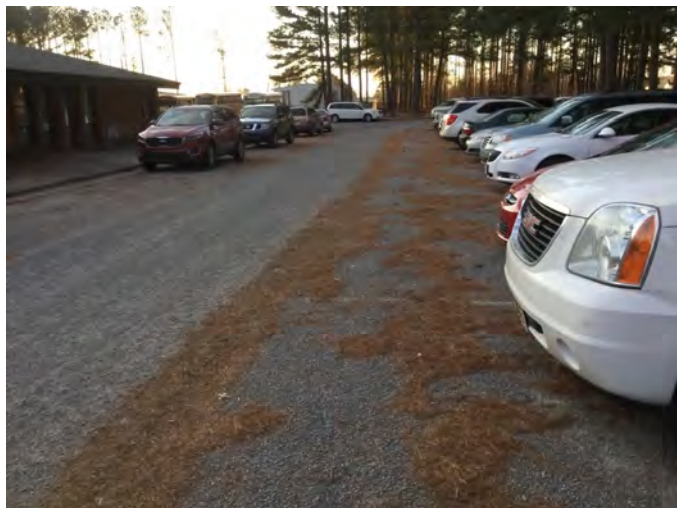
System: G4020 - Site Lighting

Location: Site
Distress: Missing
Category: Safety
Priority: 2 - Potentially Critical (Year 1)
Correction: Renew System
Qty: 46,795.00
Unit of Measure: S.F.
Estimate: \$75,668.00
Assessor Name: Eduardo Lopez
Date Created: 02/28/2017

Notes: There is no site lighting at this school. Installation of site lighting is recommended for safety.

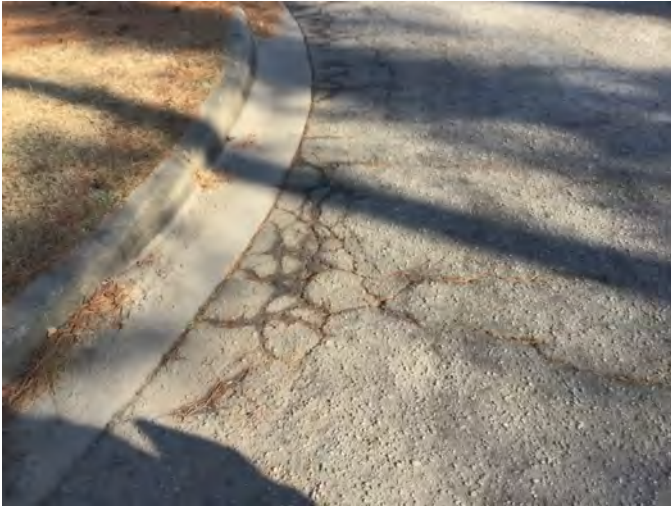
System: G2010 - Roadways

Location: Site roads
Distress: Beyond Service Life
Category: Deferred Maintenance
Priority: 3 - Necessary/Not Yet Critical (Years 2-5)
Correction: Renew System
Qty: 46,795.00
Unit of Measure: S.F.
Estimate: \$196,118.00
Assessor Name: Eduardo Lopez
Date Created: 02/16/2017

Notes: Site roads are beyond their expected service life. Surfaces are grainy. Cracking is beginning to occur. System renewal is recommended.

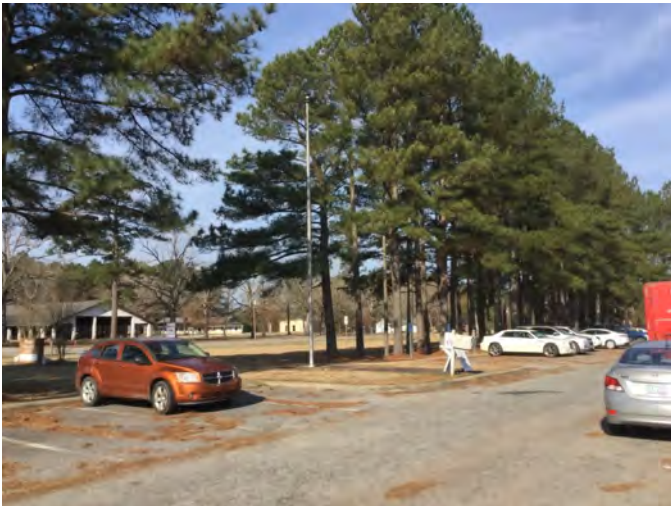
System: G2020 - Parking Lots

Location: Parking lots
Distress: Beyond Service Life
Category: Deferred Maintenance
Priority: 3 - Necessary/Not Yet Critical (Years 2-5)
Correction: Renew System
Qty: 46,795.00
Unit of Measure: S.F.
Estimate: \$68,461.00
Assessor Name: Eduardo Lopez
Date Created: 02/16/2017

Notes: Parking lot pavements are degraded with grainy surface. Striping is faded. Handicap parking space markings and signage are not up to code. There is no designated fire lane. System renewal is recommended.

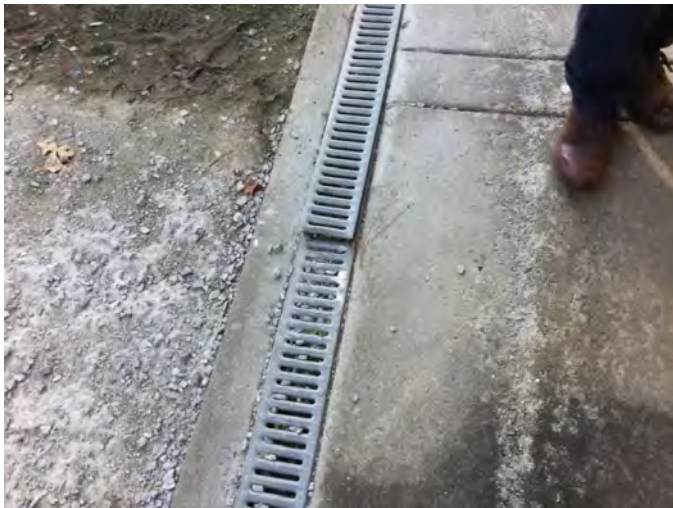
System: G2030 - Pedestrian Paving

Location: Site pedestrian concrete
Distress: Failing
Category: Deferred Maintenance / Safety
Priority: 3 - Necessary/Not Yet Critical (Years 2-5)
Correction: Renew System
Qty: 46,795.00
Unit of Measure: S.F.
Estimate: \$98,316.00
Assessor Name: Eduardo Lopez
Date Created: 02/16/2017

Notes:

Site concrete is in prematurely degraded condition, mostly adjacent to the building at eave run-off. Also missing is a path from the building to the playground. There is erosion from the edge of the concrete play surface to the playground, leading to muddy conditions. Installation of a concrete path is recommended.

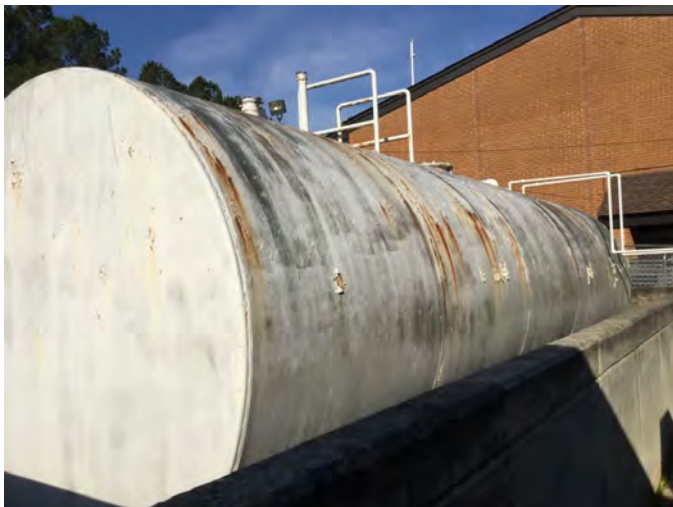
System: G3060 - Fuel Distribution

Location: Utility yard
Distress: Inadequate
Category: Deferred Maintenance
Priority: 3 - Necessary/Not Yet Critical (Years 2-5)
Correction: Remove abandoned fuel tank
Qty: 1.00
Unit of Measure: Ea.
Estimate: \$3,847.80
Assessor Name: Eduardo Lopez
Date Created: 02/16/2017

Notes: The fuel oil tank is not in use. Removal is recommended.

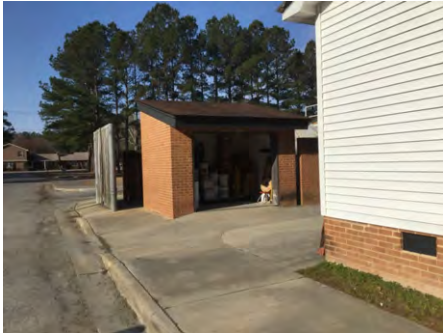
1). East Elevation - Feb 22, 2017

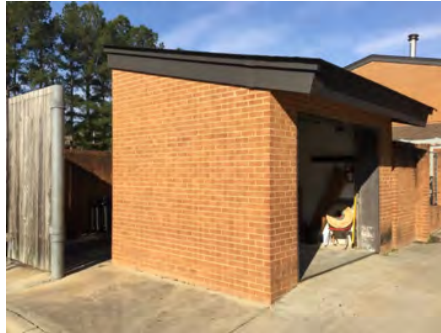
2). South Elevation - Feb 22, 2017

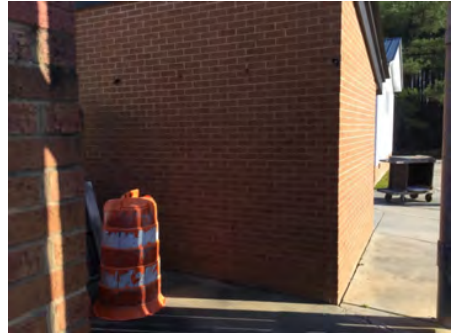
3). West Elevation - Feb 22, 2017

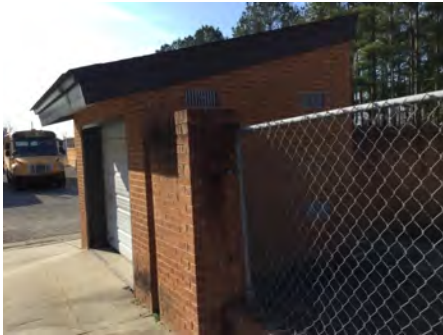
4). North Elevation - Feb 22, 2017

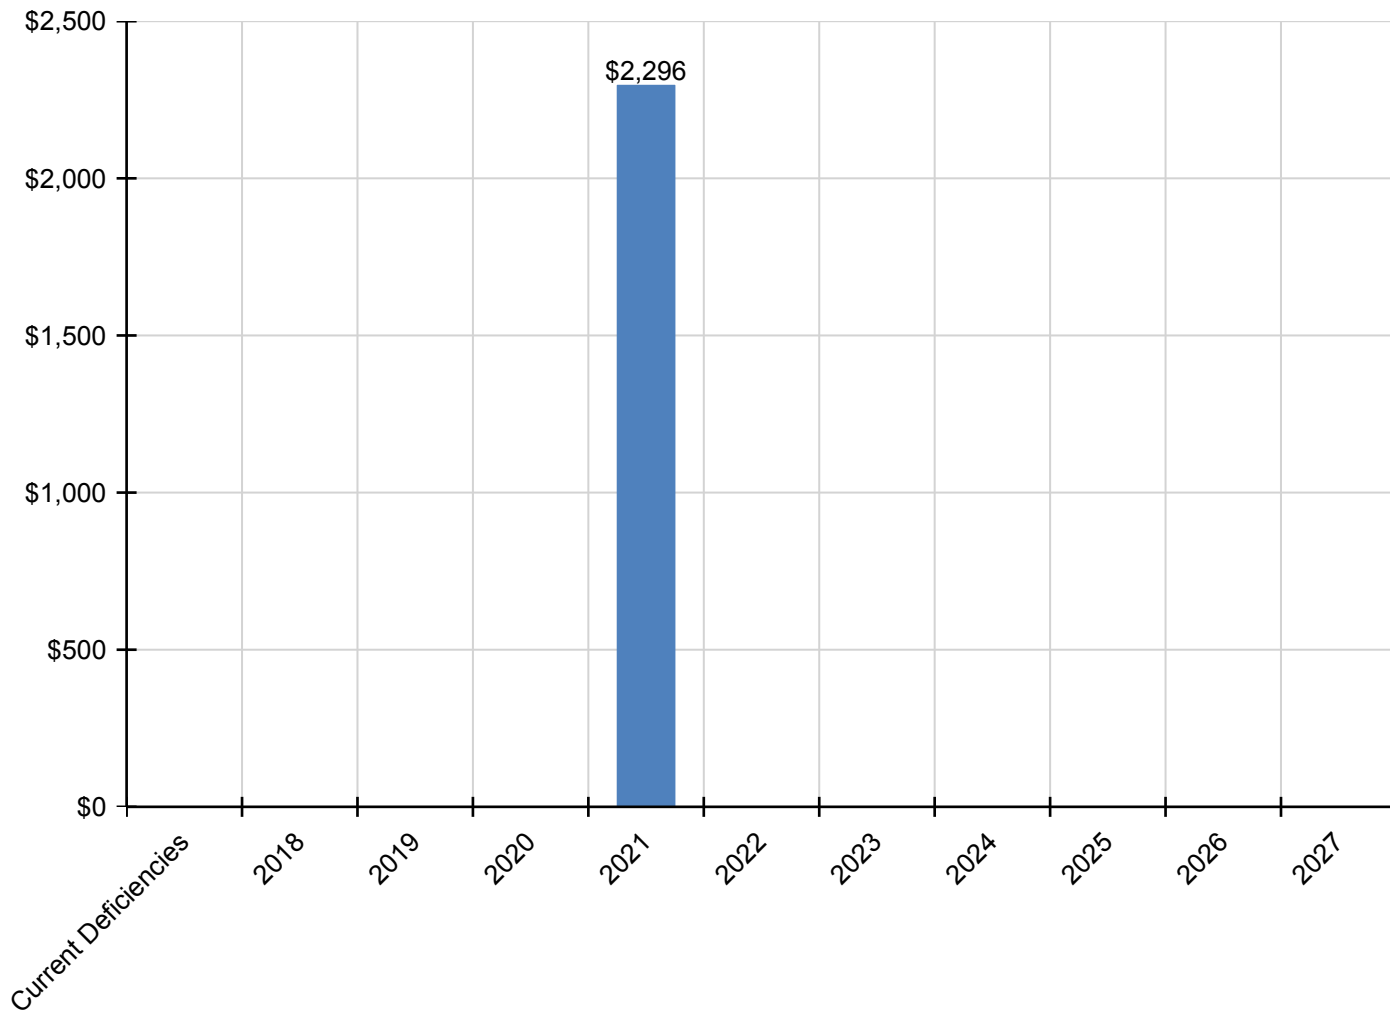
Forecasted Capital Renewal Requirement

The following chart shows the current building deficiencies and forecasting capital renewal or sustainment requirements over the next ten years.

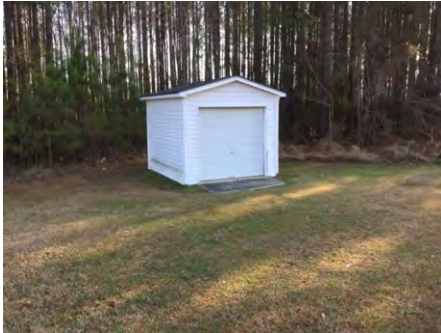
1). Northeast Elevations - Feb 22, 2017

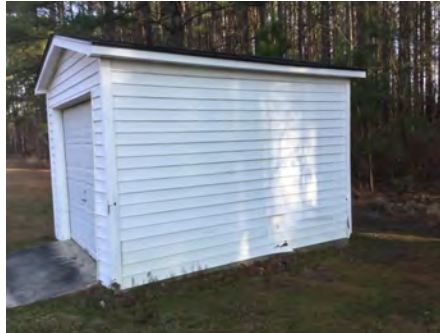
2). South Elevation - Feb 22, 2017

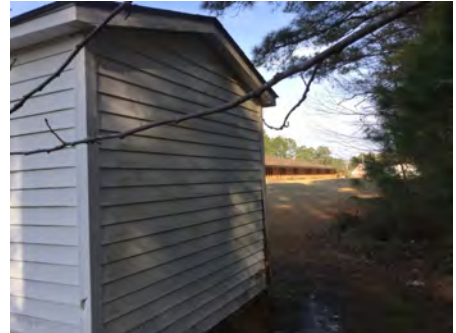
3). West Elevation - Feb 22, 2017

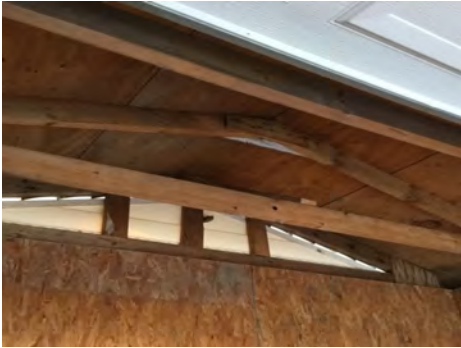
System: B1020 - Roof Construction

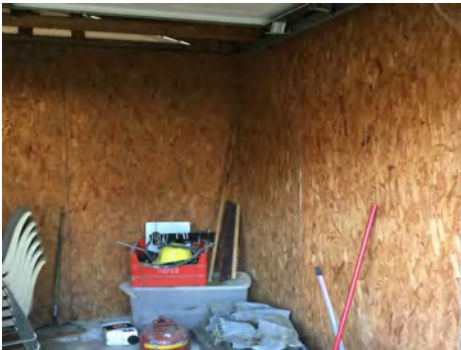
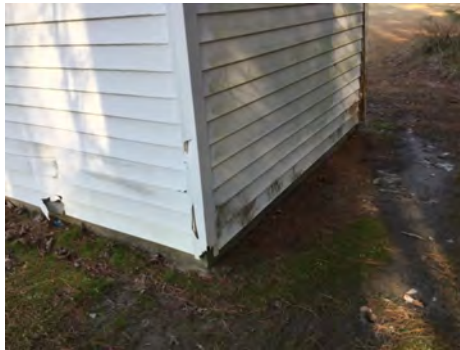
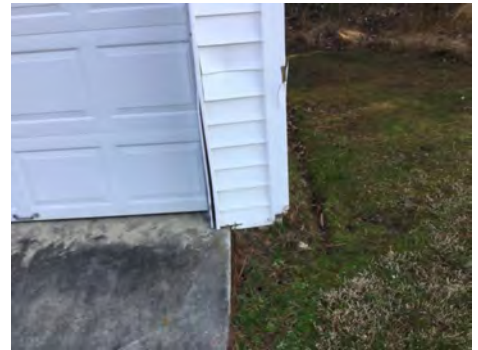
System: B2010 - Exterior Walls

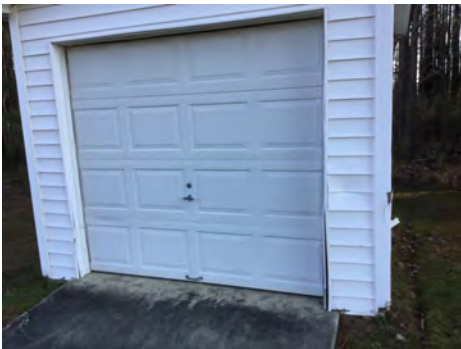
System: B2030 - Exterior Doors

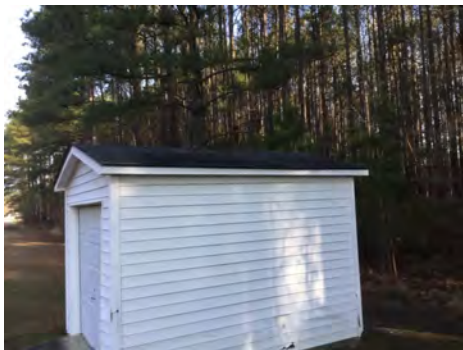
System: B3010140 - Asphalt Shingles

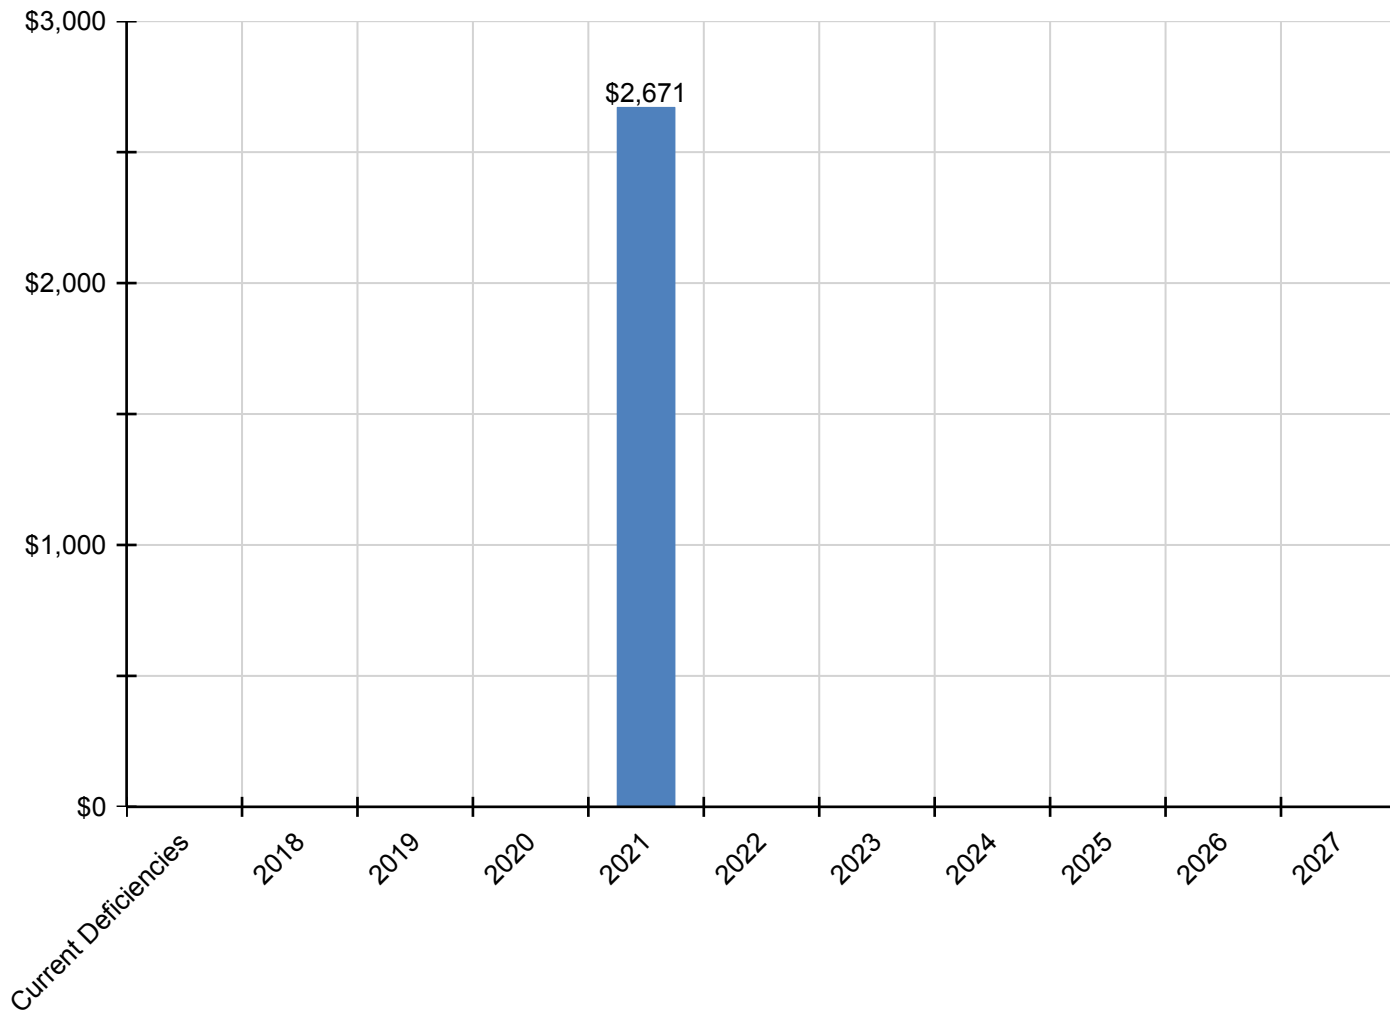
Forecasted Capital Renewal Requirement

The following chart shows the current building deficiencies and forecasting capital renewal or sustainment requirements over the next ten years.

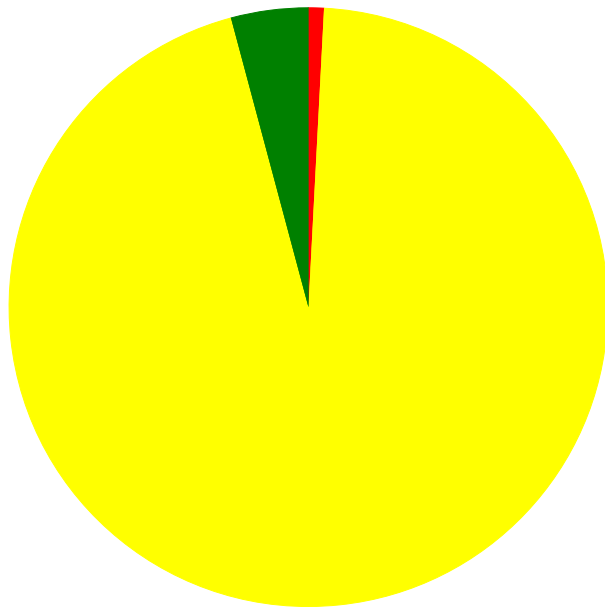
Deficiencies By Priority

- 1 - Currently Critical (Immediate) - \$60,457.32
- 2 - Potentially Critical (Year 1)
- 3 - Necessary/Not Yet Critical (Years 2-5) - \$6,914,345.08
- 4 - Recommended (Years 6-10) - \$303,228.00
- 5 - Codes or Standards Compliance

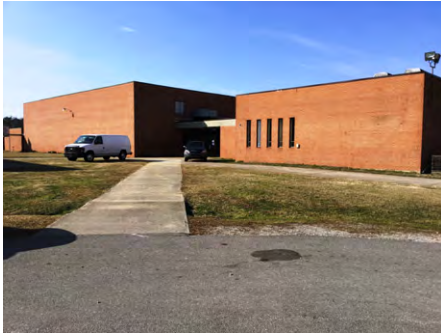
1). East Elevation - Feb 07, 2017

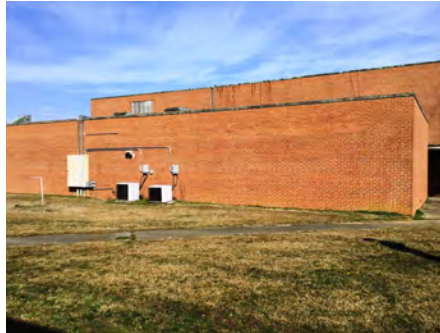
2). South Elevation - Feb 07, 2017

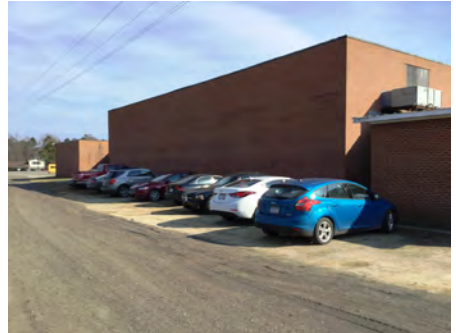
3). West Elevation - Feb 07, 2017

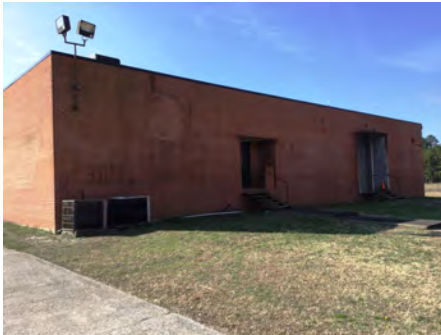
4). North Elevation - Feb 07, 2017

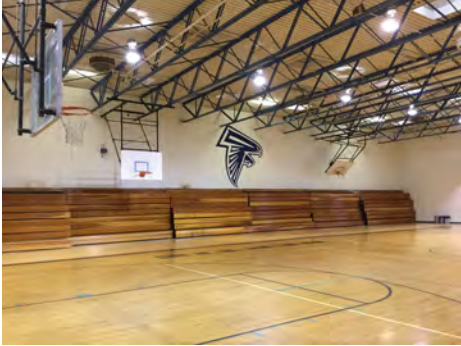
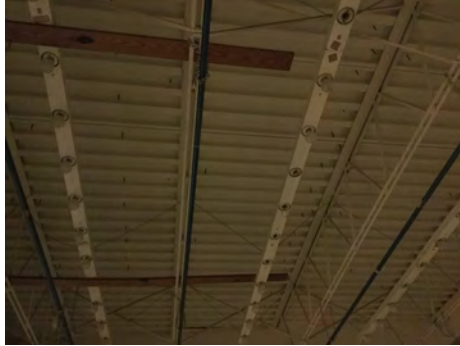
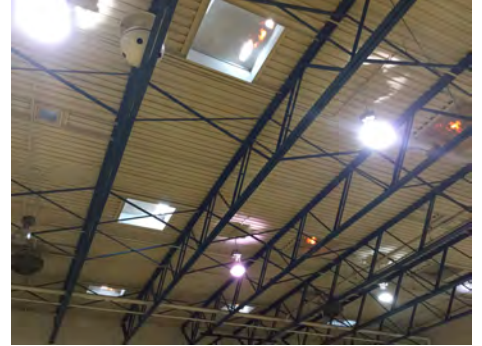
System: B1020 - Roof Construction

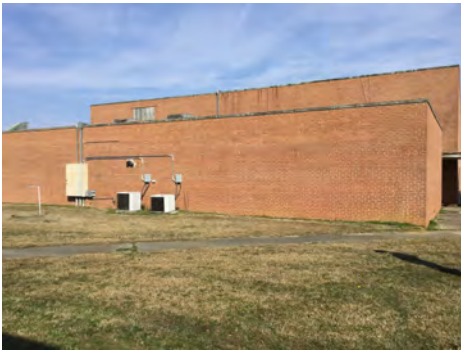
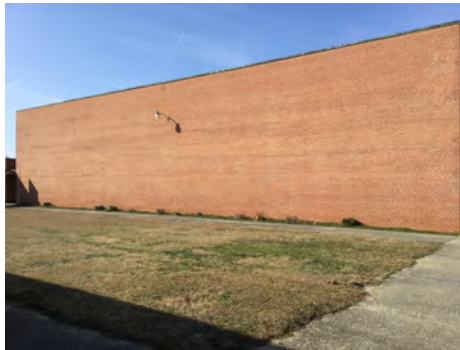
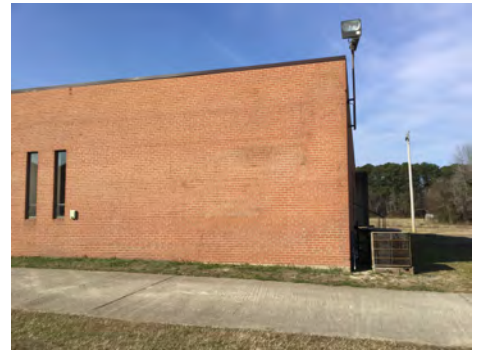
System: B2010 - Exterior Walls

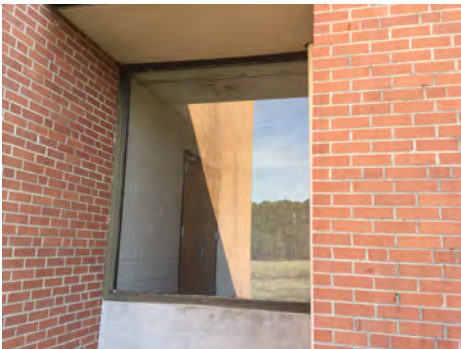
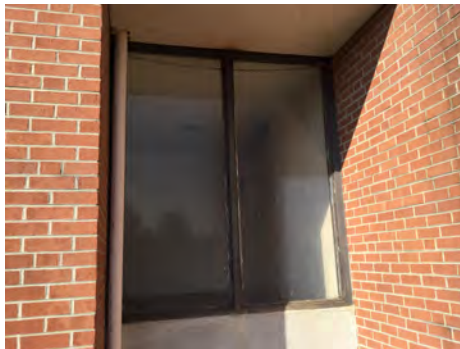
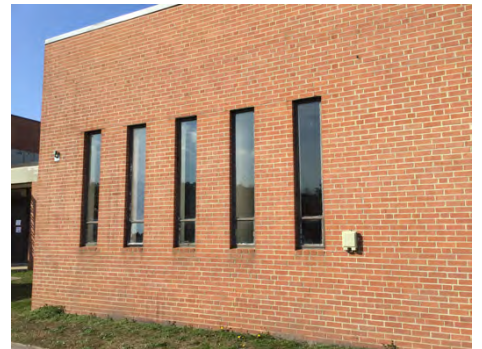
System: B2020 - Exterior Windows

Note: The exterior windows are beyond their service life and should be replaced.

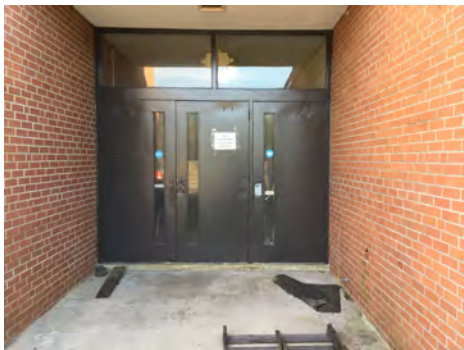
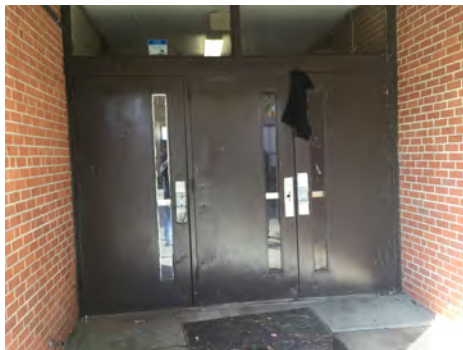
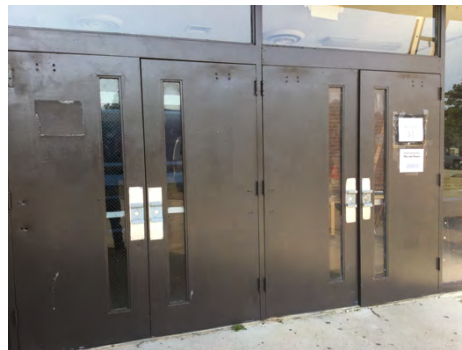
System: B2030 - Exterior Doors

Note: The exterior doors are beyond their service life and should be replaced.
