NC School District/080 Bertie County/Middle School

Bertie Middle

Campus Assessment Report

March 8, 2017

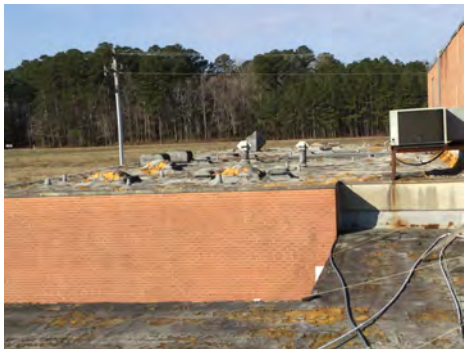
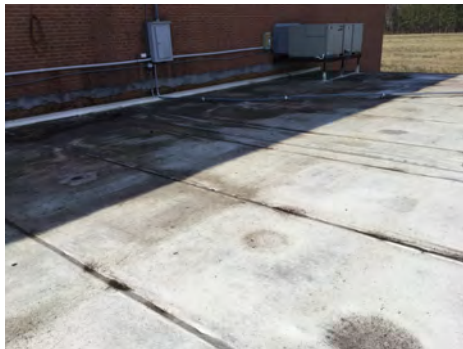
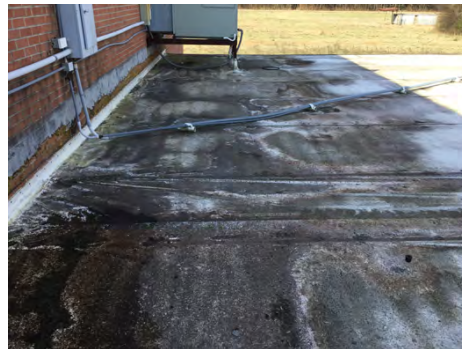
System: B3010120 - Single Ply Membrane

Note: The older roof is beyond its service life and the newer roof is in poor condition and should be replaced.

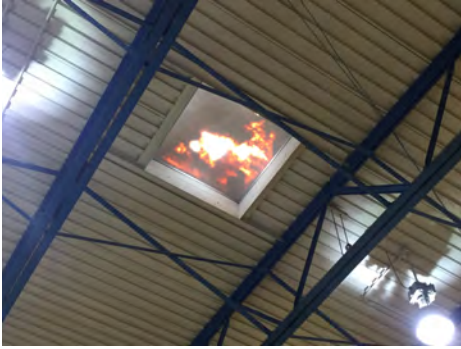
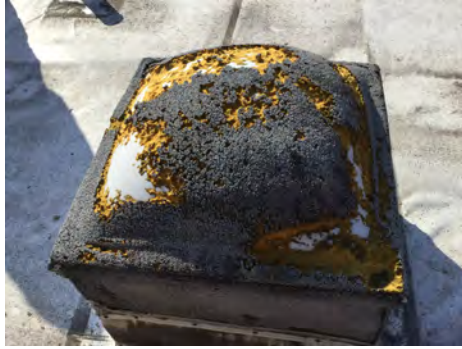
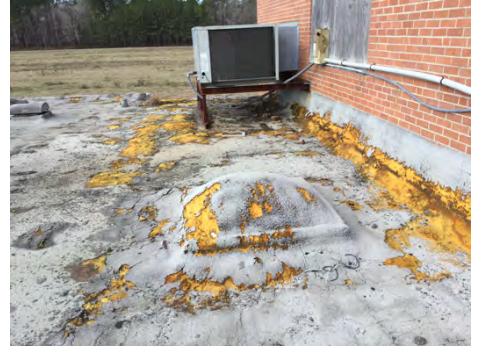
System: B3020 - Roof Openings

Note: The skylights are beyond their service life and have been covered by the foam roofing system, they should be replaced.

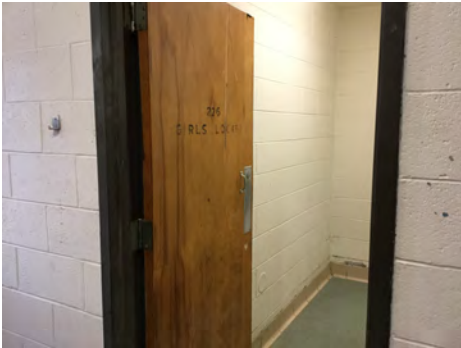
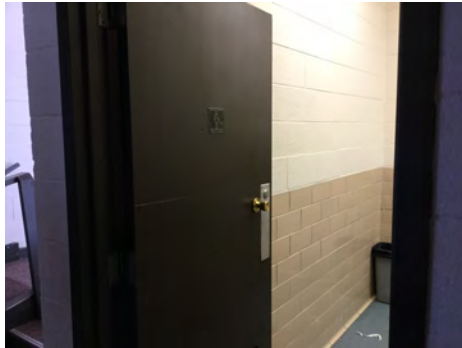
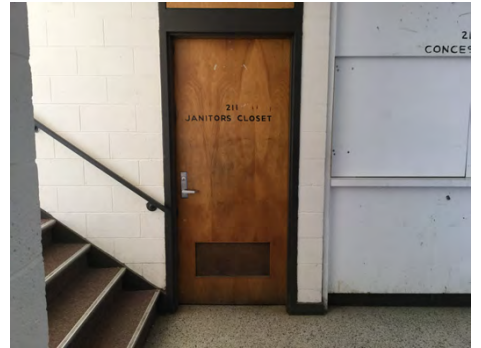
System: C1020 - Interior Doors

Note: The interior doors are beyond their service life and should be replaced.

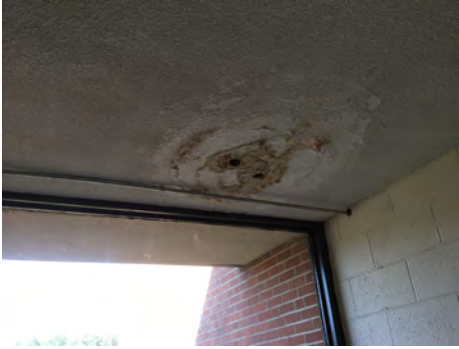
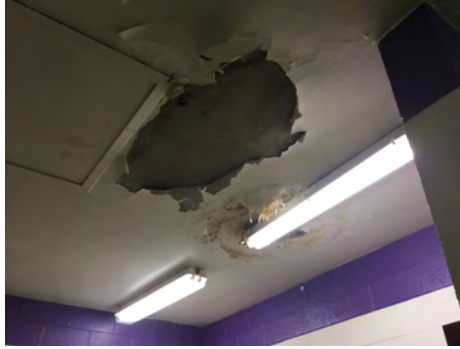
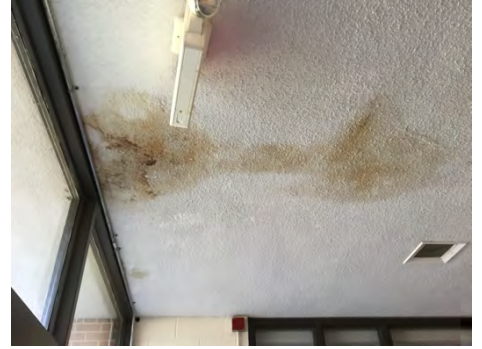
System: C3030 - Ceiling Finishes

Note: The ceiling finishes are beyond their service life because of water damage and it should be replaced.

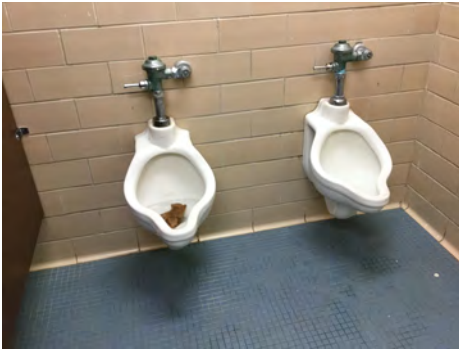
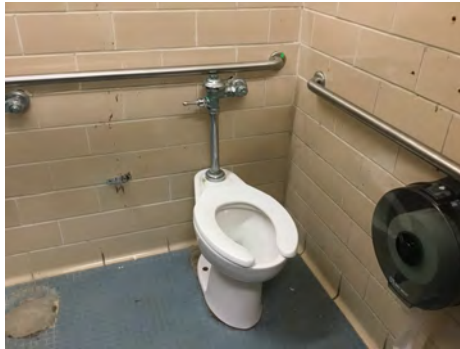
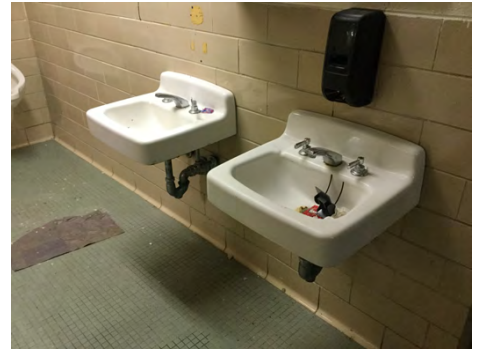
System: D2010 - Plumbing Fixtures

Note: The plumbing fixtures are beyond their service life and should be replaced.

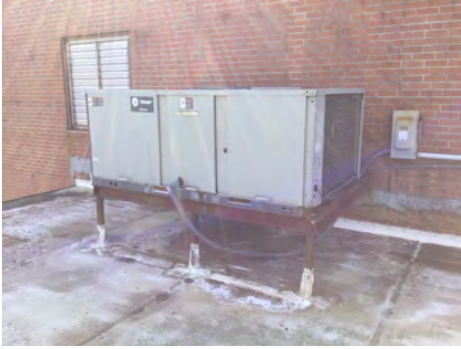
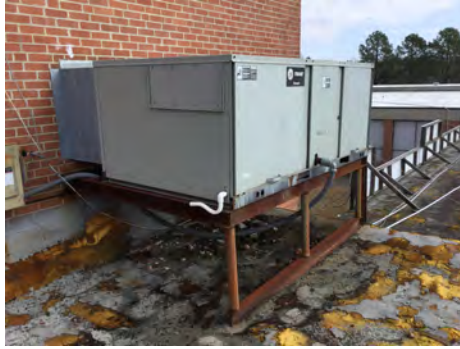
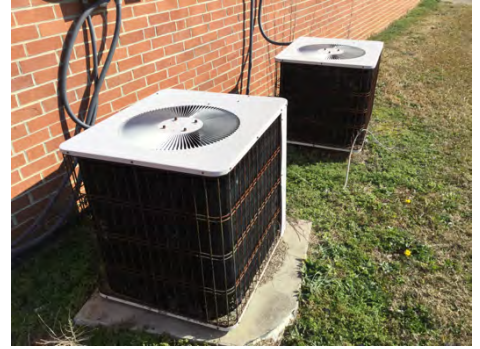
System: D3050 - Terminal & Package Units

Note: The terminal and package units are beyond their service life and should be replaced.

Notes: The terminal and package units are beyond their service life and should be replaced.

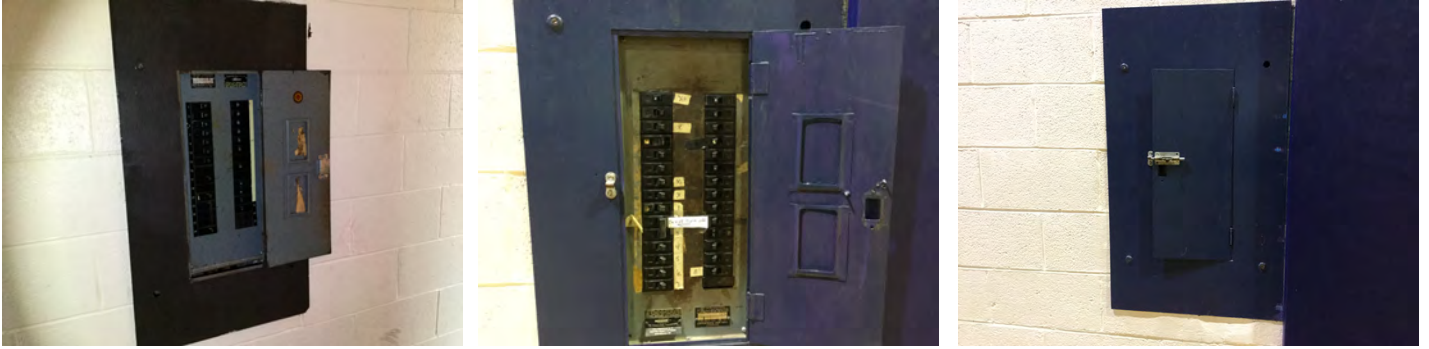
System: D5020 - Branch Wiring

Note: The branch wiring system is beyond its service life and should be replaced.

Notes: The branch wiring system is beyond its service life and should be replaced.

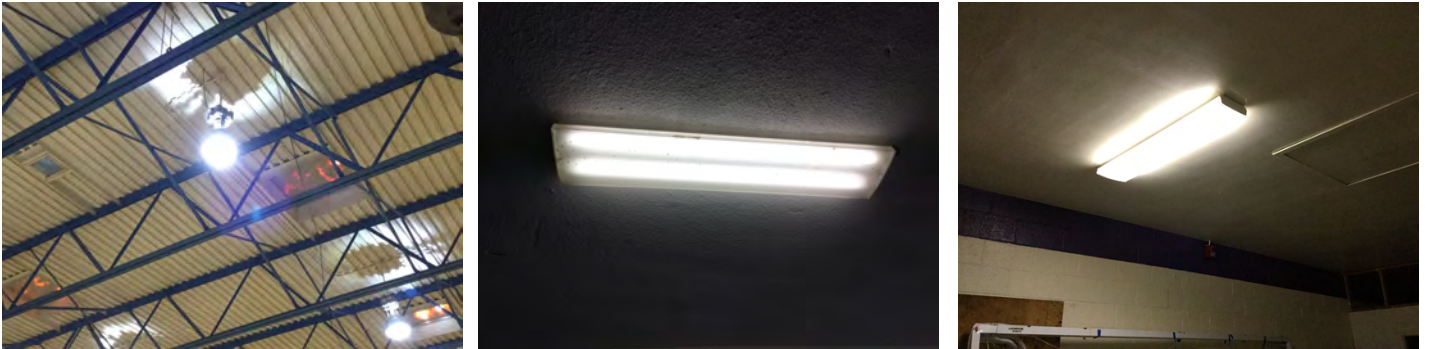
System: D5020 - Lighting

Note: The lighting fixtures are beyond their service life and should be replaced.

Notes: The lighting fixtures are beyond their service life and should be replaced.

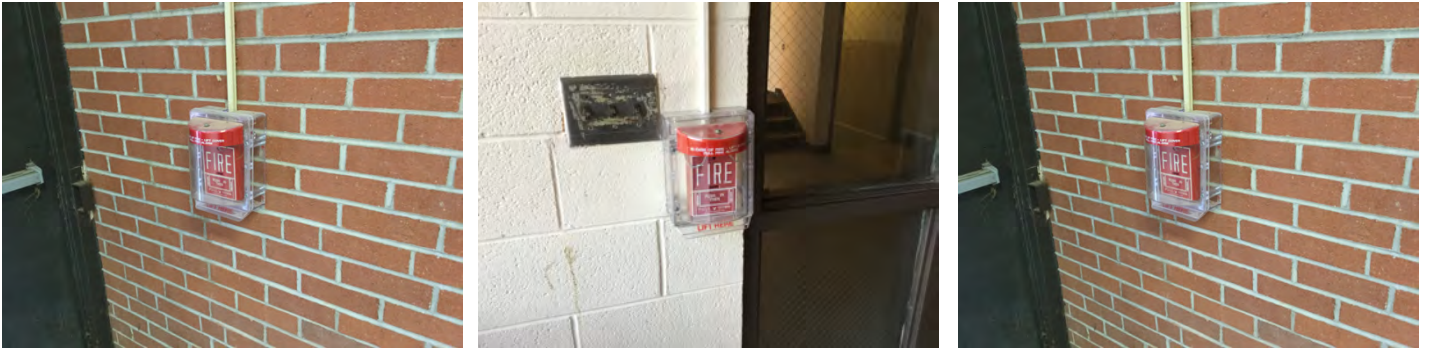
System: D5030910 - Fire & Alarm Systems

Note: The fire alarm system is beyond its service life and should be replaced.

Notes: The fire alarm system is beyond its service life and should be replaced.

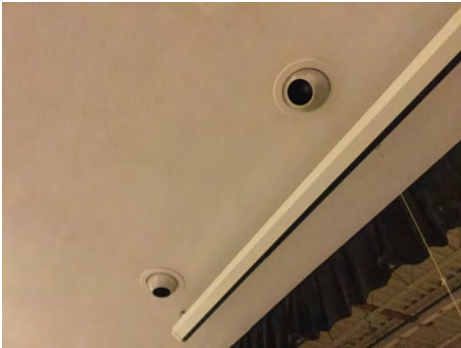
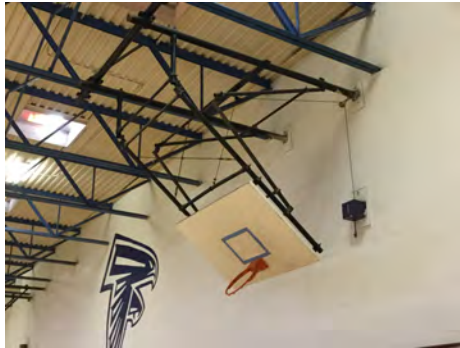
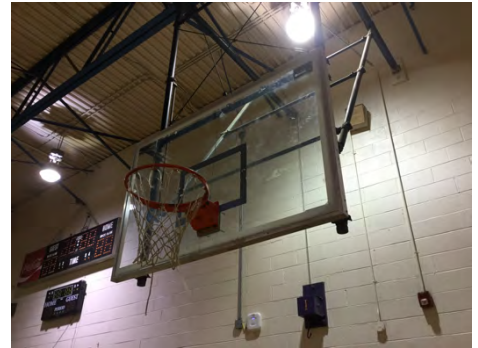
System: E1020 - Institutional Equipment

Note: The institutional equipment system is beyond its service life and should be replaced.

Notes: The institutional equipment system is beyond its service life and should be replaced.

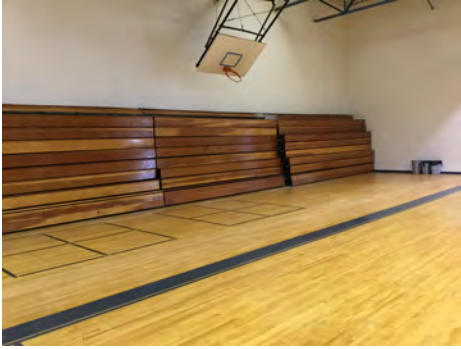
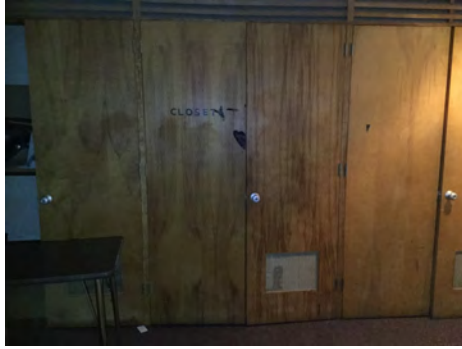
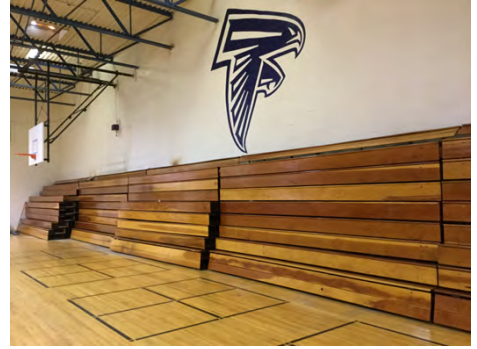
System: E2010 - Fixed Furnishings

Note: The fixed furnishings are beyond their service life and should be replaced.

Notes: The fixed furnishings are beyond their service life and should be replaced.

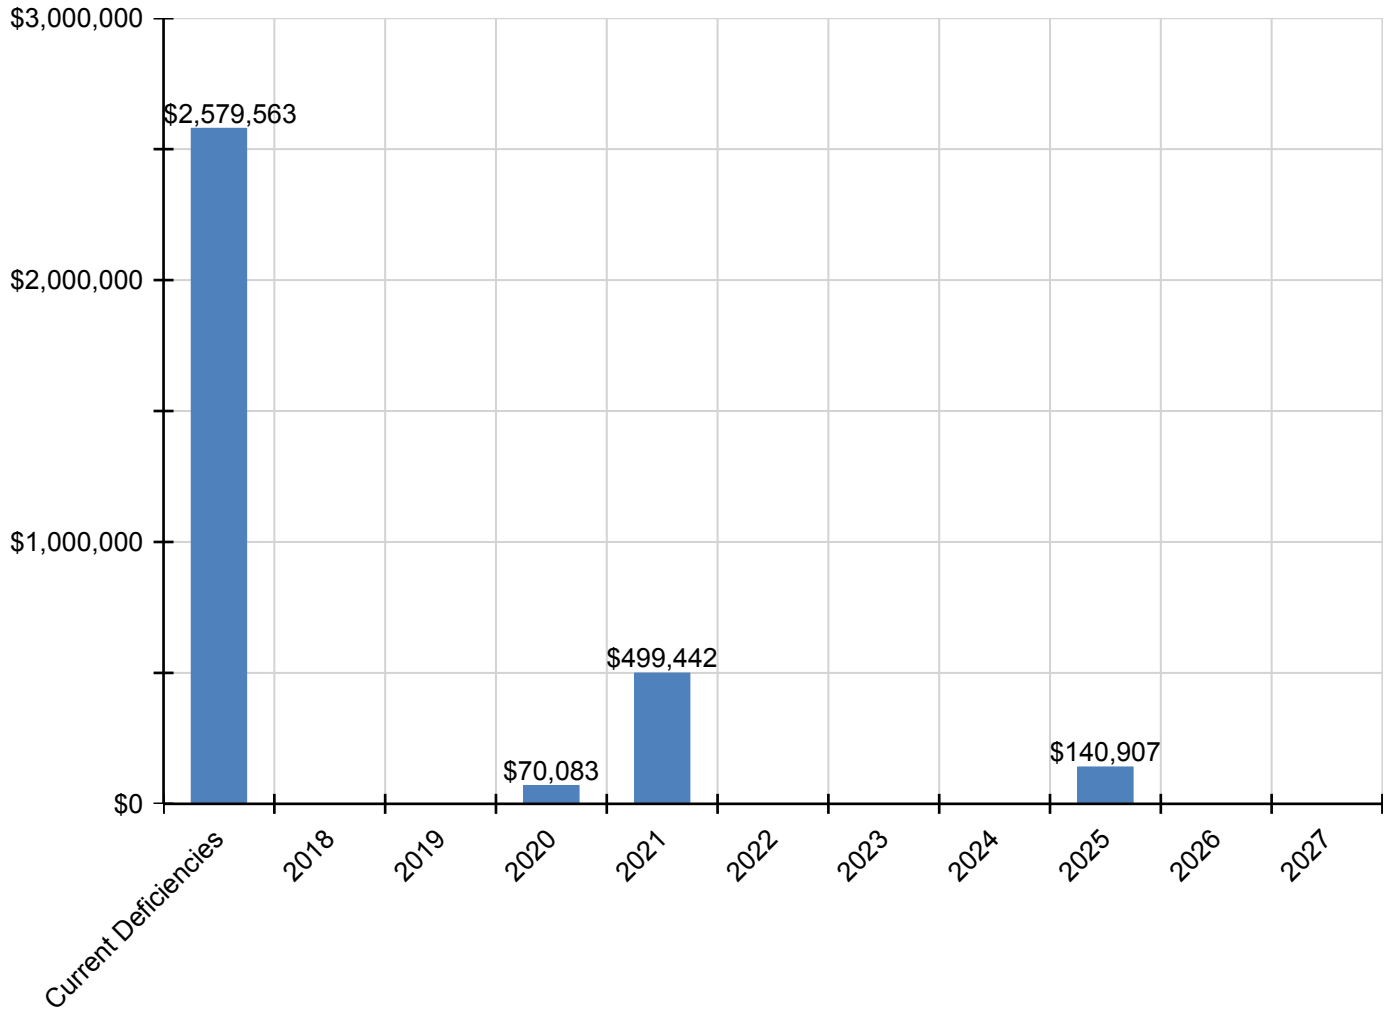
Forecasted Capital Renewal Requirement

The following chart shows the current building deficiencies and forecasting capital renewal or sustainment requirements over the next ten years.

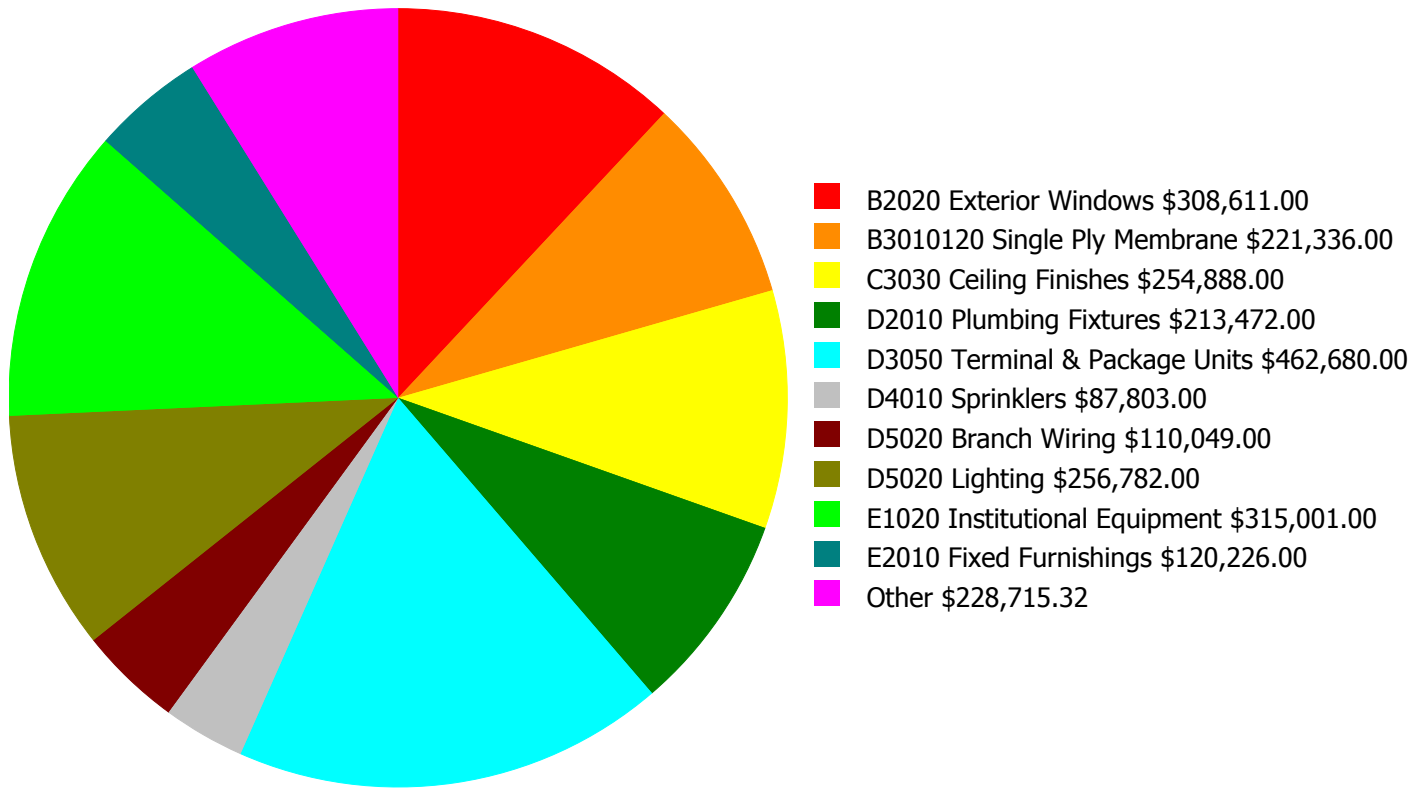
Deficiency Summary by System

Current deficiencies included assemblies that have reached or exceeded their design life or components of the assemblies that are in need of repair. Assemblies that have reached their design life are identified as current deficiencies and assigned the distress 'Beyond Useful Life'. The following chart lists all current deficiencies associated with this facility.

Budget Estimate Total: \$2,579,563.32

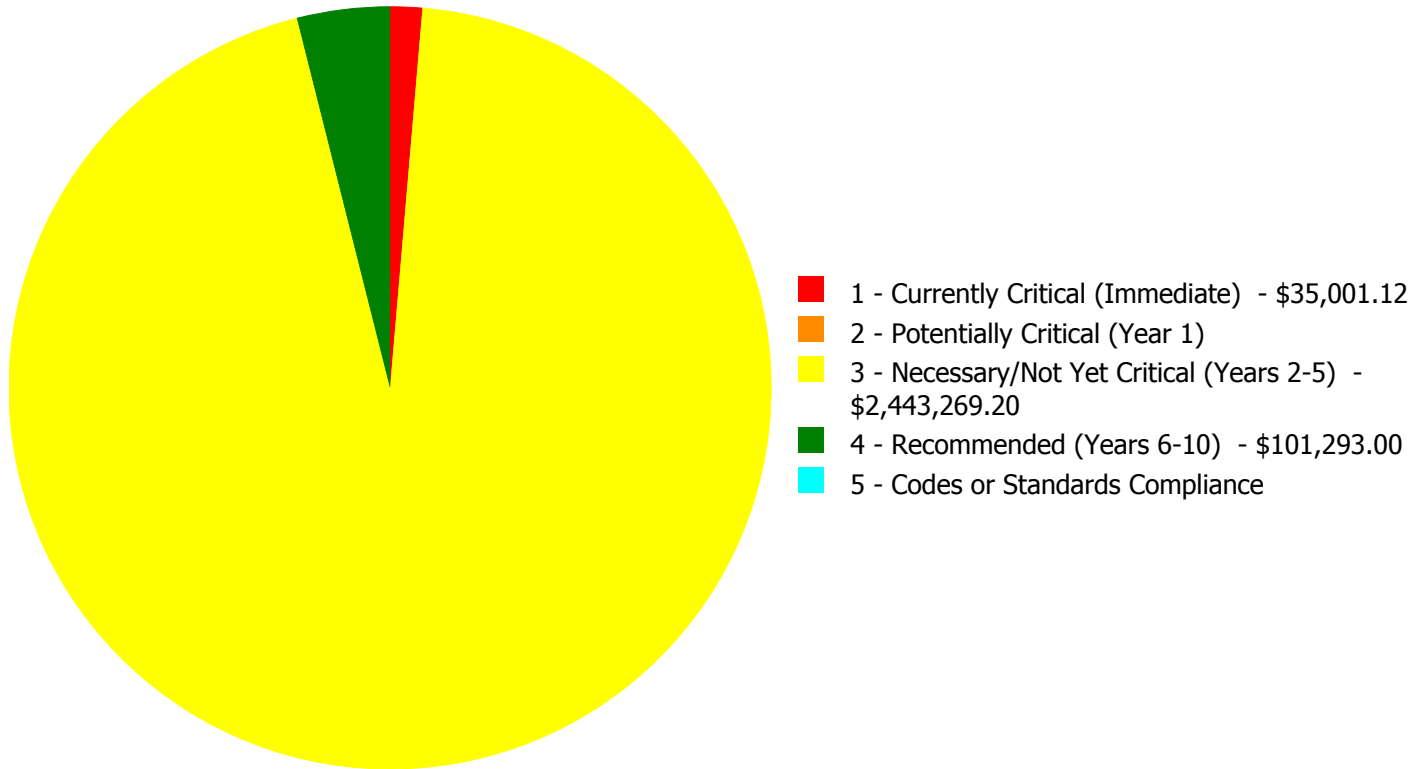
Deficiency Summary by Priority

The following chart shows the total repair costs broken down by priority. Assessors assigned deficiencies within eCOMET to one of the following priority categories:

Budget Estimate Total: \$2,579,563.32

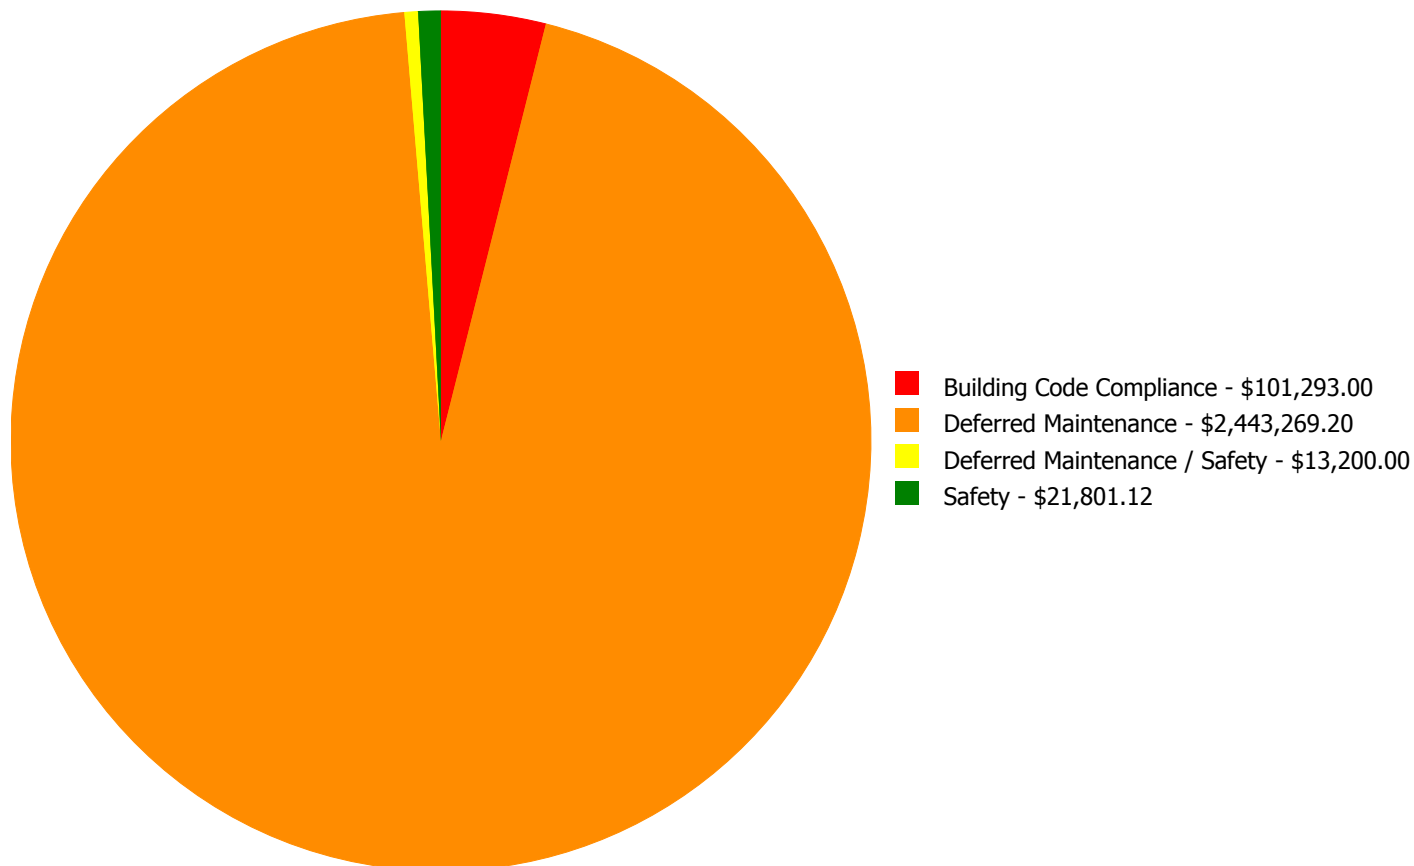
Deficiency Summary by Category

The following chart shows the total repair costs broken down by deficiency categories. Assessors assigned deficiencies to one of the following categories:

Budget Estimate Total: \$2,579,563.32

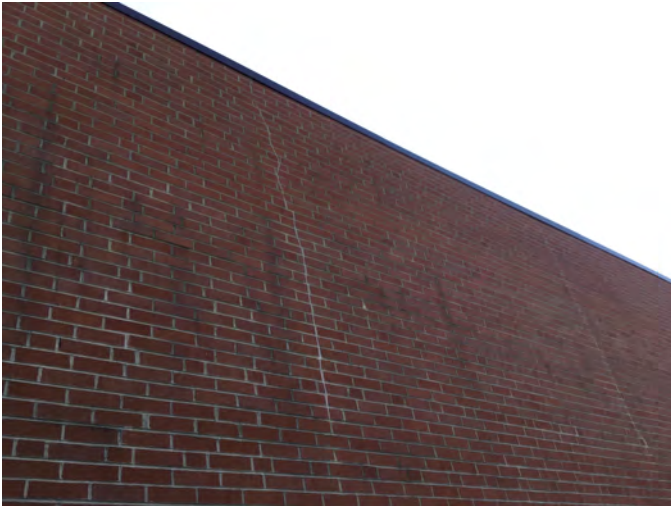
System: B2010 - Exterior Walls

Location: Exterior walls
Distress: Failing
Category: Deferred Maintenance / Safety
Priority: 1 - Currently Critical (Immediate)
Correction: Engineering Study-2016-11-15 17:41:59
Qty: 1.00
Unit of Measure: Ea.
Estimate: \$13,200.00
Assessor Name: Somnath Das
Date Created: 02/03/2017

Notes: The exterior walls have visible cracks which should be studied by a professional engineer.

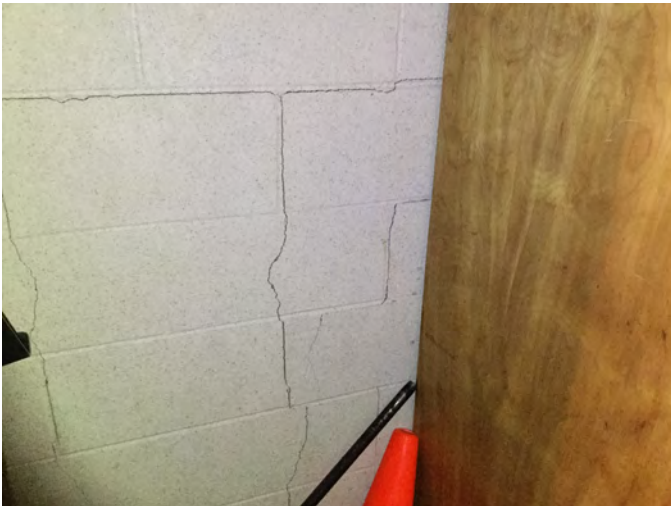
System: C1010 - Partitions

Location: Auditorium
Distress: Failing
Category: Safety
Priority: 1 - Currently Critical (Immediate)
Correction: Engineering Study
Qty: 1.00
Unit of Measure: Ea.
Estimate: \$13,200.00
Assessor Name: Somnath Das
Date Created: 02/03/2017

Notes: There are visible cracks on the partition wall which should be studied by a professional engineer.

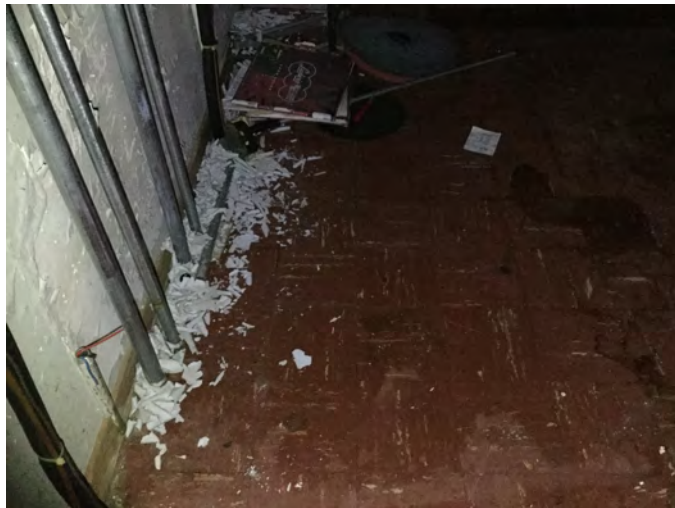
System: C3020 - Floor Finishes

Location: Mechanical Room near auditorium
Distress: Beyond Service Life
Category: Safety
Priority: 1 - Currently Critical (Immediate)
Correction: Replace vinyl tile flooring
Qty: 80.00
Unit of Measure: S.Y.
Estimate: \$8,601.12
Assessor Name: Somnath Das
Date Created: 02/03/2017

Notes: The vinyl flooring in the room has suspected material which should be abated and removed.

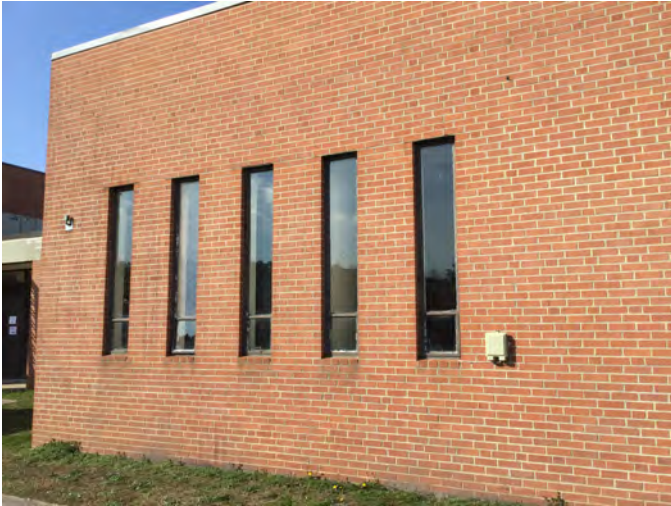
System: B2020 - Exterior Windows

Location: Exterior Walls
Distress: Beyond Service Life
Category: Deferred Maintenance
Priority: 3 - Necessary/Not Yet Critical (Years 2-5)
Correction: Renew System
Qty: 21,515.00
Unit of Measure: S.F.
Estimate: \$308,611.00
Assessor Name: Somnath Das
Date Created: 02/07/2017

Notes: The exterior windows are beyond their service life and should be replaced.

Note: The exterior windows are beyond their service life and should be replaced.

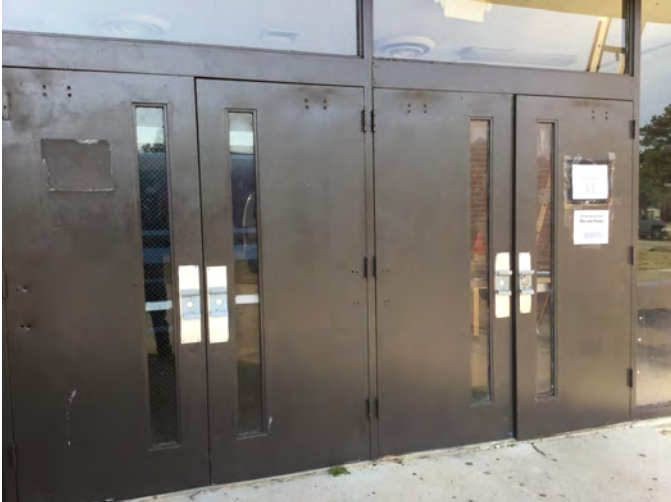
System: B2030 - Exterior Doors

Location: Exterior Walls
Distress: Beyond Service Life
Category: Deferred Maintenance
Priority: 3 - Necessary/Not Yet Critical (Years 2-5)
Correction: Renew System
Qty: 21,515.00
Unit of Measure: S.F.
Estimate: \$19,407.00
Assessor Name: Somnath Das
Date Created: 02/07/2017

Notes: The exterior doors are beyond their service life and should be replaced.

Note: The exterior doors are beyond their service life and should be replaced.

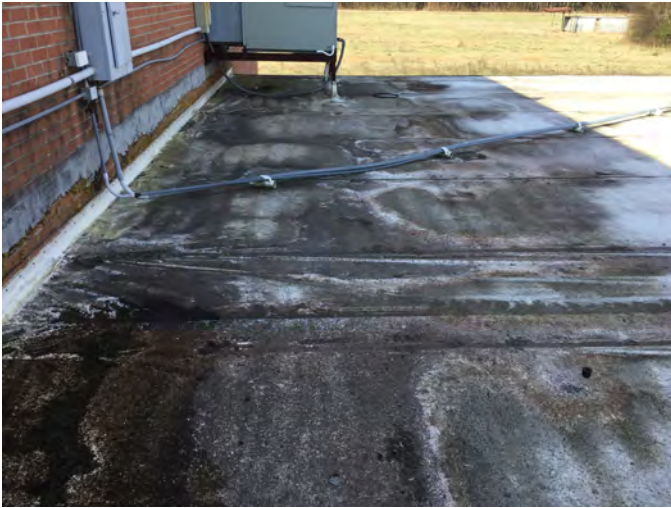
System: B3010120 - Single Ply Membrane

Location: Roof
Distress: Failing
Category: Deferred Maintenance
Priority: 3 - Necessary/Not Yet Critical (Years 2-5)
Correction: Renew System
Qty: 21,140.00
Unit of Measure: S.F.
Estimate: \$221,336.00
Assessor Name: Somnath Das
Date Created: 02/07/2017

Notes: The older roof is beyond its service life and the newer roof is in poor condition and should be replaced.

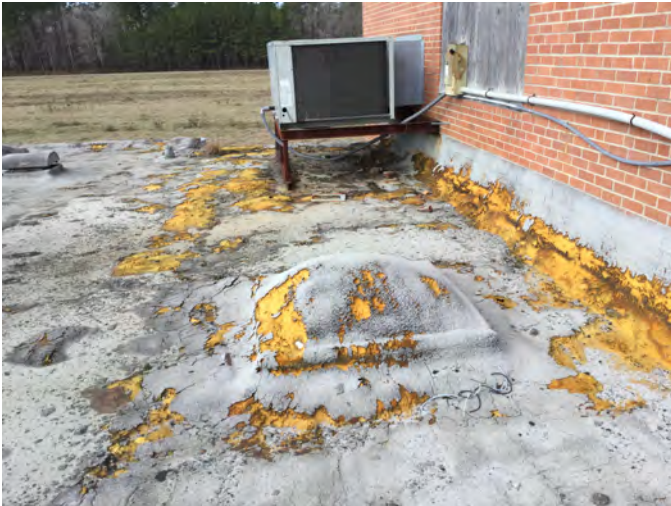
System: B3020 - Roof Openings

Location: Roof
Distress: Beyond Service Life
Category: Deferred Maintenance
Priority: 3 - Necessary/Not Yet Critical (Years 2-5)
Correction: Renew System
Qty: 21,515.00
Unit of Measure: S.F.
Estimate: \$4,970.00
Assessor Name: Somnath Das
Date Created: 02/07/2017

Notes: The skylights are beyond their service life and have been covered by the foam roofing system, they should be replaced.

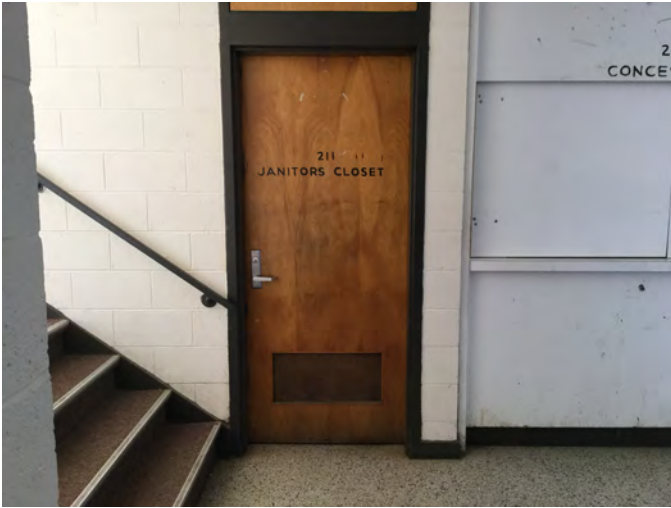
System: C1020 - Interior Doors

Location: Throughout Building
Distress: Beyond Service Life
Category: Deferred Maintenance
Priority: 3 - Necessary/Not Yet Critical (Years 2-5)
Correction: Renew System
Qty: 21,515.00
Unit of Measure: S.F.
Estimate: \$58,930.00
Assessor Name: Somnath Das
Date Created: 02/07/2017

Notes: The interior doors are beyond their service life and should be replaced.

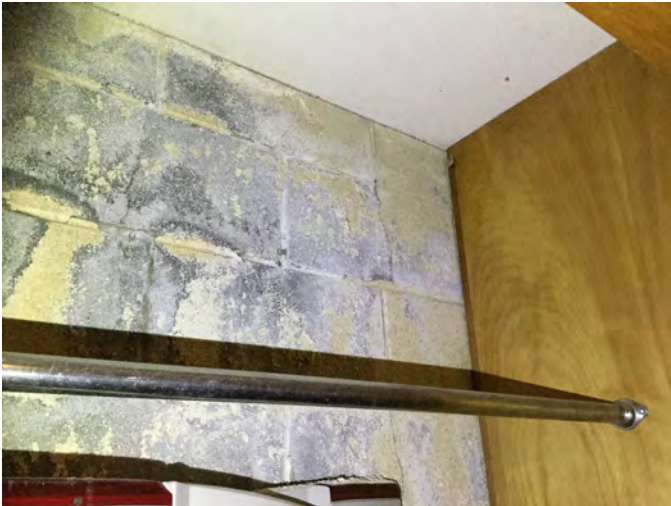
System: C3010 - Wall Finishes

Location: Auditorium storage and locker rooms
Distress: Beyond Service Life
Category: Deferred Maintenance
Priority: 3 - Necessary/Not Yet Critical (Years 2-5)
Correction: Repaint the walls
Qty: 8,160.00
Unit of Measure: S.F.
Estimate: \$10,771.20
Assessor Name: Somnath Das
Date Created: 02/03/2017

Notes: The wall finishes are in poor condition and should be replaced.

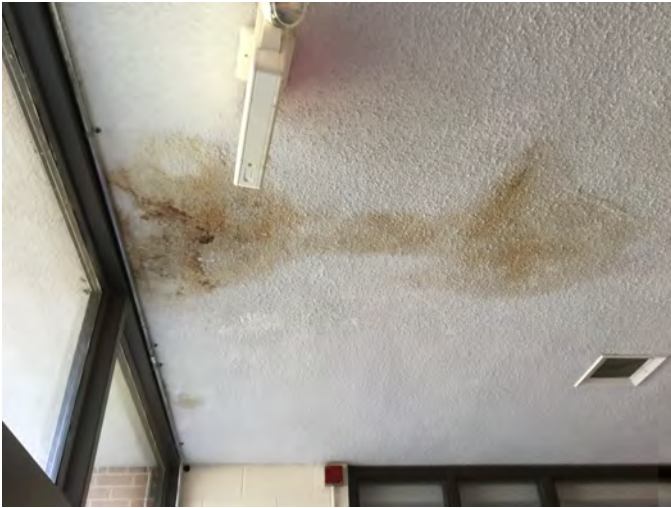
System: C3030 - Ceiling Finishes

Location: Throughout Building
Distress: Beyond Service Life
Category: Deferred Maintenance
Priority: 3 - Necessary/Not Yet Critical (Years 2-5)
Correction: Renew System
Qty: 21,515.00
Unit of Measure: S.F.
Estimate: \$254,888.00
Assessor Name: Somnath Das
Date Created: 02/07/2017

Notes: The ceiling finishes are beyond their service life because of water damage and it should be replaced.

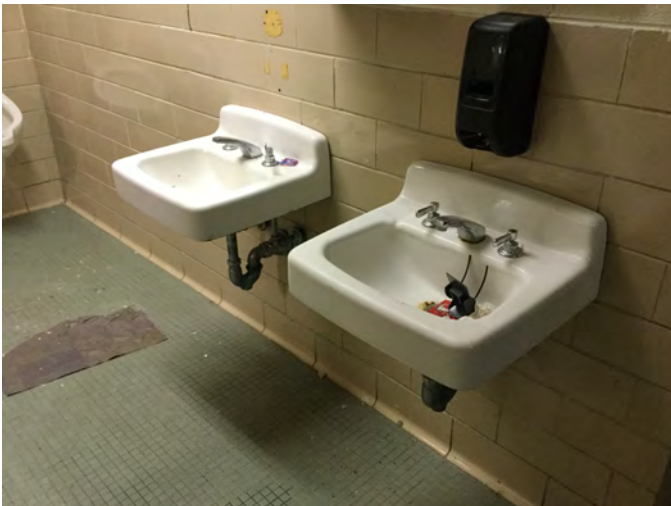
System: D2010 - Plumbing Fixtures

Location: Throughout Building
Distress: Beyond Service Life
Category: Deferred Maintenance
Priority: 3 - Necessary/Not Yet Critical (Years 2-5)
Correction: Renew System
Qty: 21,515.00
Unit of Measure: S.F.
Estimate: \$213,472.00
Assessor Name: Somnath Das
Date Created: 02/07/2017

Notes: The plumbing fixtures are beyond their service life and should be replaced.

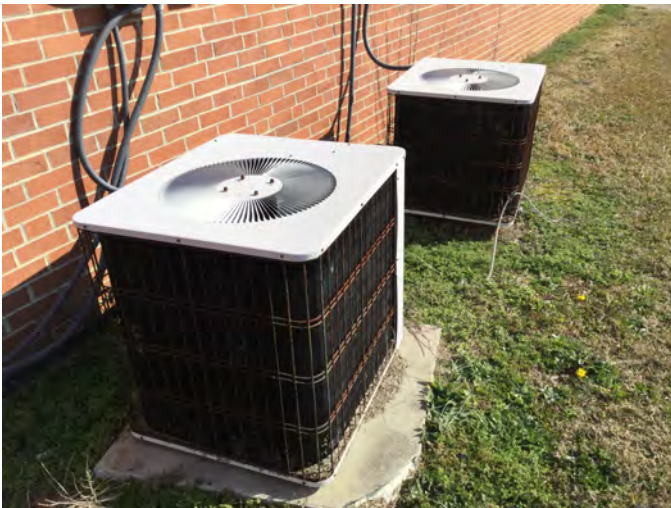
System: D3050 - Terminal & Package Units

Location: Throughout Building
Distress: Beyond Service Life
Category: Deferred Maintenance
Priority: 3 - Necessary/Not Yet Critical (Years 2-5)
Correction: Renew System
Qty: 21,515.00
Unit of Measure: S.F.
Estimate: \$462,680.00
Assessor Name: Somnath Das
Date Created: 02/07/2017

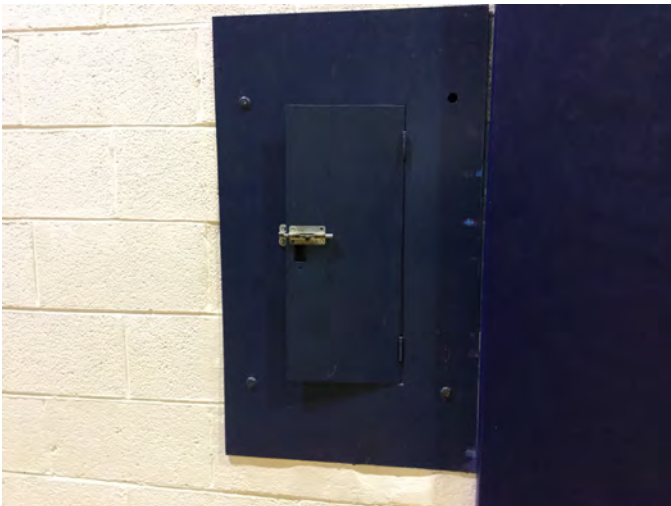
System: D5020 - Branch Wiring

Location: Throughout Building
Distress: Beyond Service Life
Category: Deferred Maintenance
Priority: 3 - Necessary/Not Yet Critical (Years 2-5)
Correction: Renew System
Qty: 21,515.00
Unit of Measure: S.F.
Estimate: \$110,049.00
Assessor Name: Somnath Das
Date Created: 02/07/2017

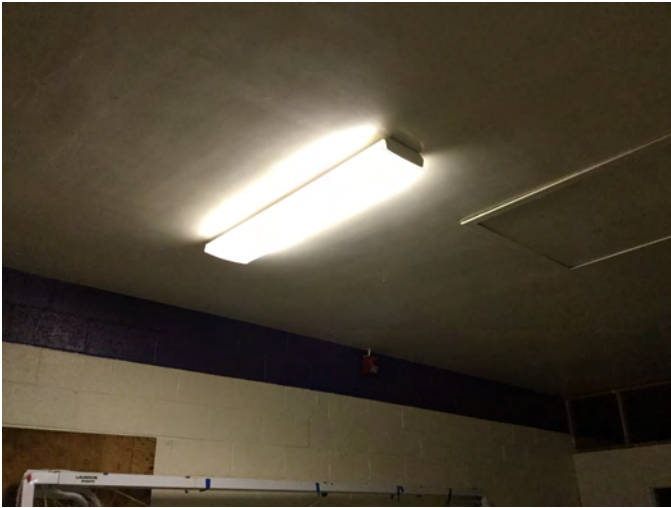
System: D5020 - Lighting

Location: Throughout Building
Distress: Beyond Service Life
Category: Deferred Maintenance
Priority: 3 - Necessary/Not Yet Critical (Years 2-5)
Correction: Renew System
Qty: 21,515.00
Unit of Measure: S.F.
Estimate: \$256,782.00
Assessor Name: Somnath Das
Date Created: 02/07/2017

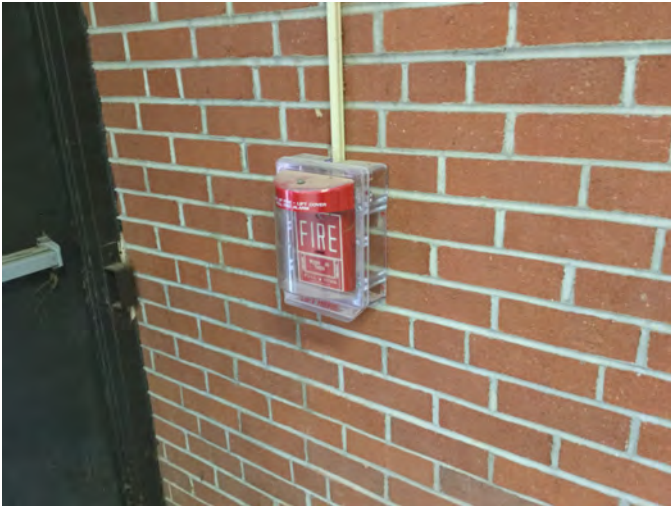
System: D5030910 - Fire & Alarm Systems

Location: Throughout Building
Distress: Beyond Service Life
Category: Deferred Maintenance
Priority: 3 - Necessary/Not Yet Critical (Years 2-5)
Correction: Renew System
Qty: 21,515.00
Unit of Measure: S.F.
Estimate: \$86,146.00
Assessor Name: Somnath Das
Date Created: 02/07/2017

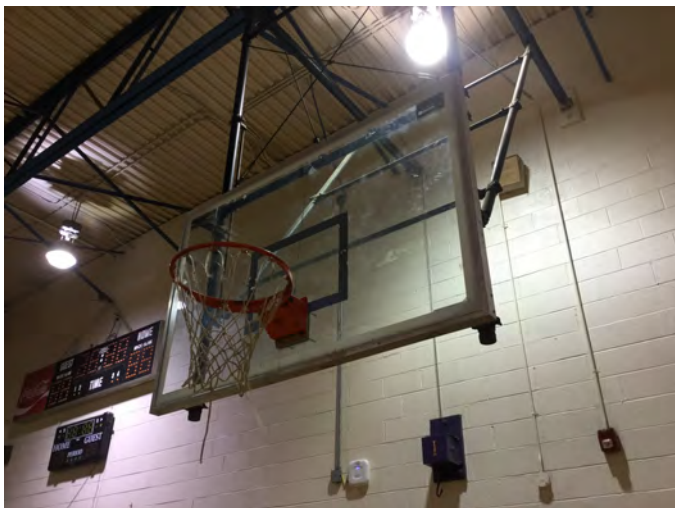
System: E1020 - Institutional Equipment

Location: Throughout Building
Distress: Beyond Service Life
Category: Deferred Maintenance
Priority: 3 - Necessary/Not Yet Critical (Years 2-5)
Correction: Renew System
Qty: 21,515.00
Unit of Measure: S.F.
Estimate: \$315,001.00
Assessor Name: Somnath Das
Date Created: 02/07/2017

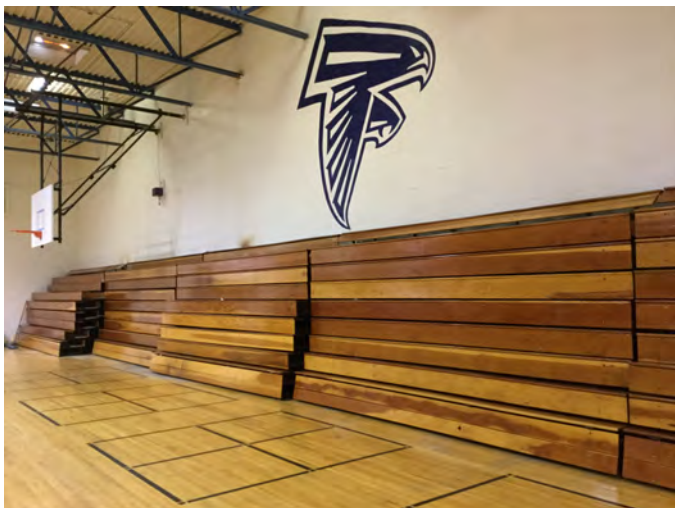
System: E2010 - Fixed Furnishings

Location: Throughout Building
Distress: Beyond Service Life
Category: Deferred Maintenance
Priority: 3 - Necessary/Not Yet Critical (Years 2-5)
Correction: Renew System
Qty: 21,515.00
Unit of Measure: S.F.
Estimate: \$120,226.00
Assessor Name: Somnath Das
Date Created: 02/07/2017

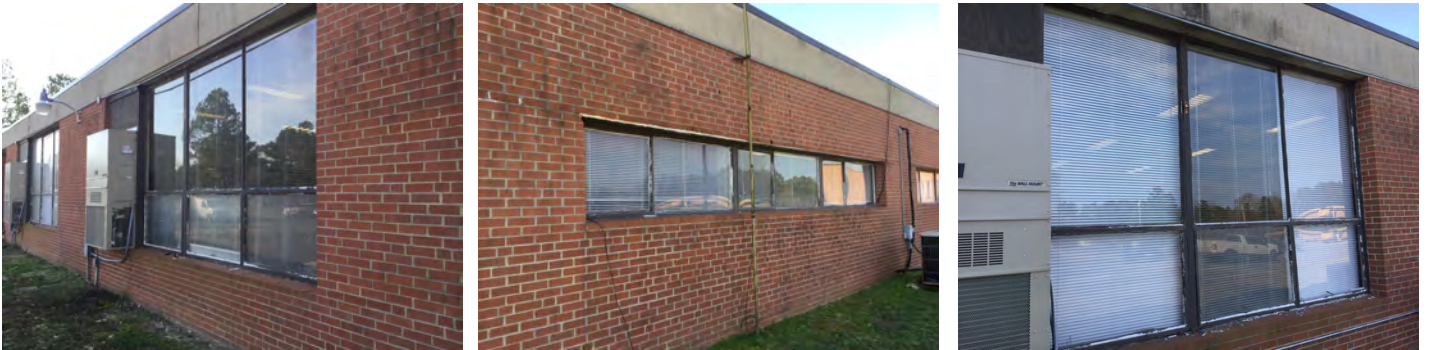
System: B2020 - Exterior Windows

Note: The exterior windows are beyond their service life and should be replaced.

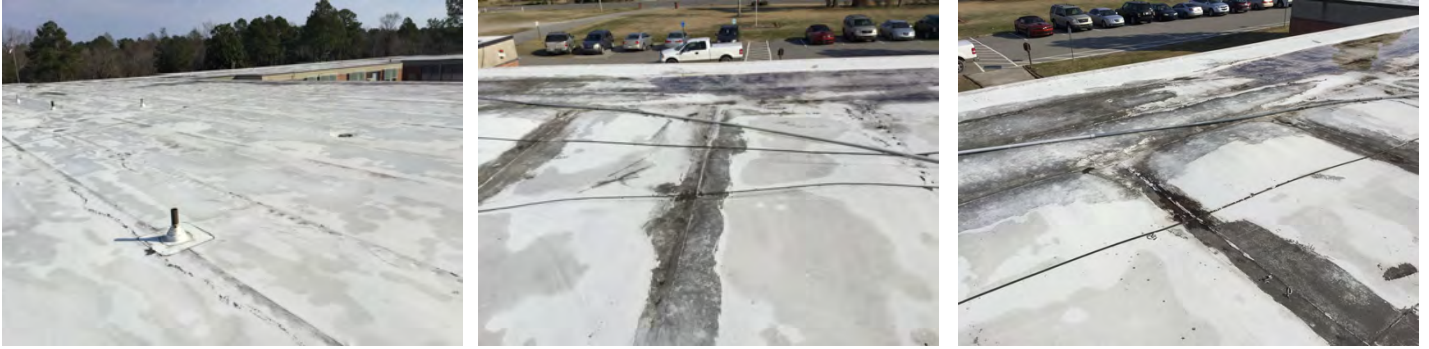
System: B3010120 - Single Ply Membrane

Note: The roof covering is in poor condition and has reported leaks, the roof covering should be replaced.

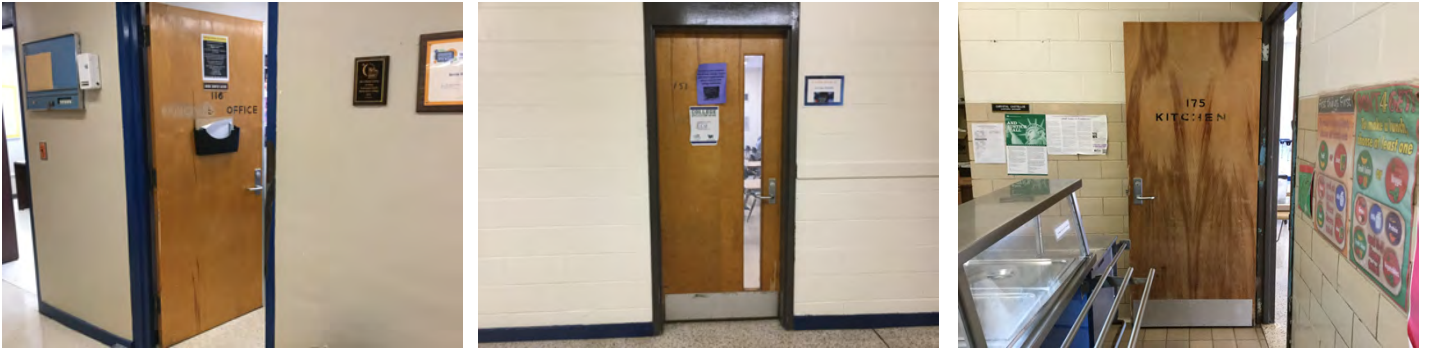
System: C1020 - Interior Doors

Note: The interior doors are beyond their service life and should be replaced.

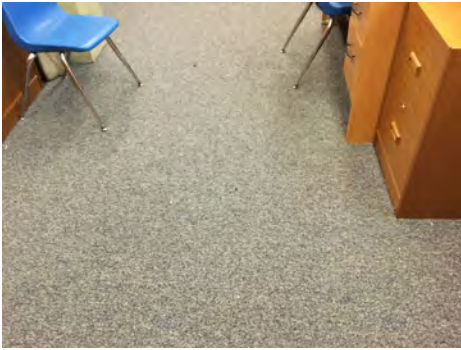
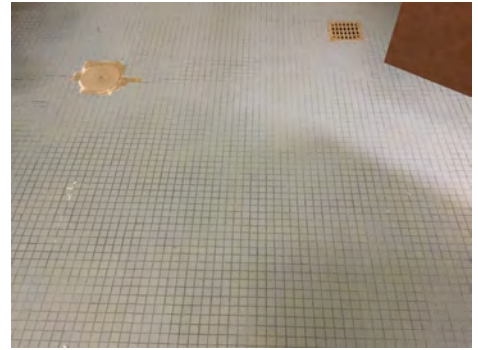
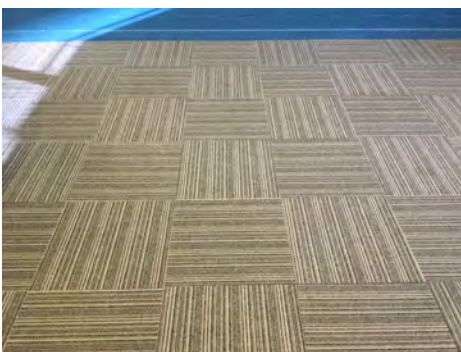
System: C3020 - Floor Finishes

Note: Carpet needs to be replaced.

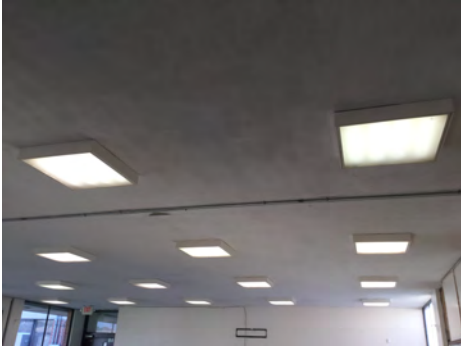
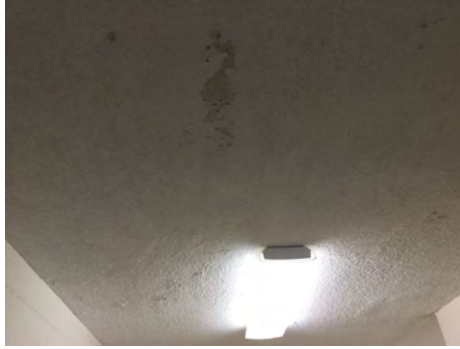
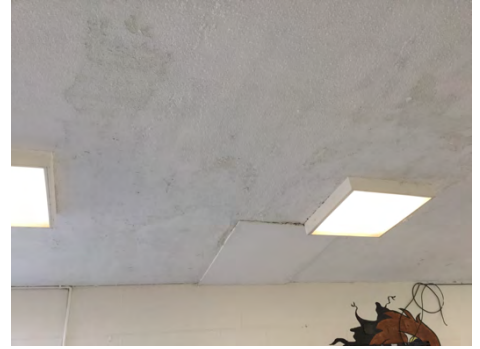
System: C3030 - Ceiling Finishes

Note: The ceiling finishes are beyond their service life and should be replaced.

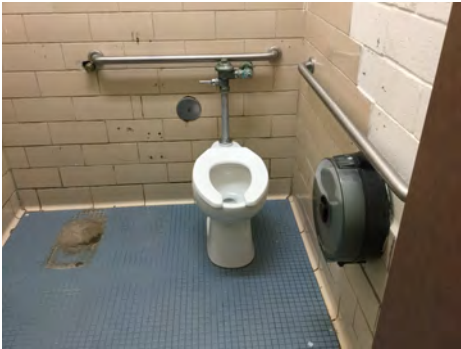
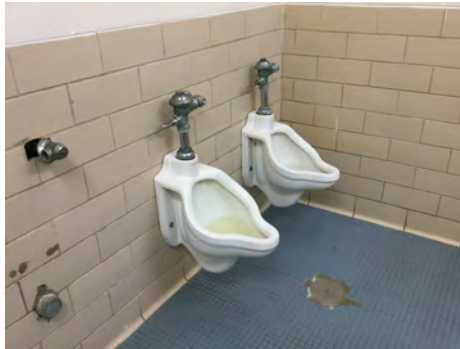
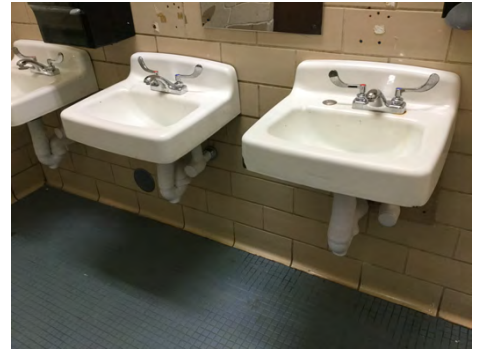
System: D2010 - Plumbing Fixtures

Note: The plumbing fixtures are beyond their service life and should be replaced.

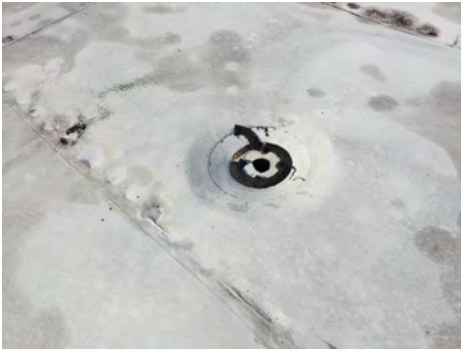
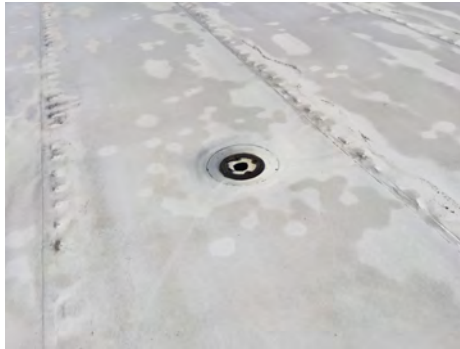
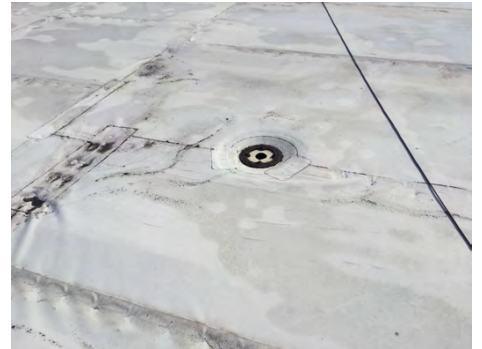
System: D2040 - Rain Water Drainage

Note: The roof drainage system is beyond its service life and should be replaced.

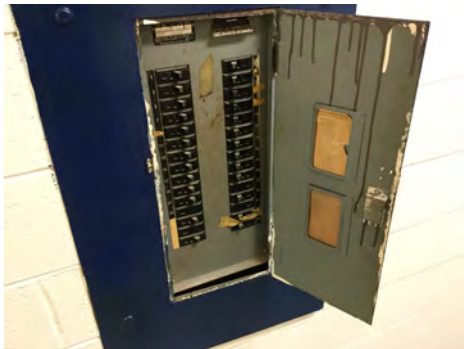
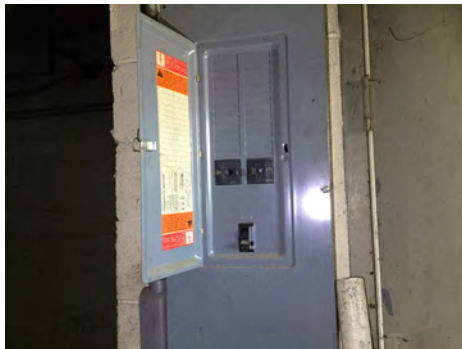
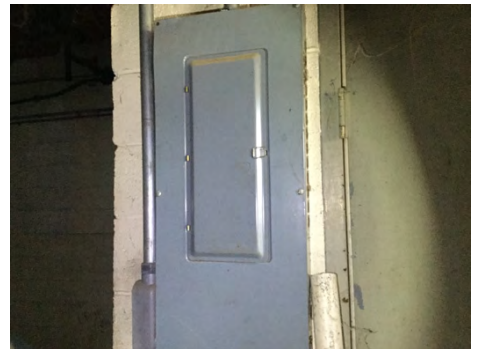
System: D5020 - Branch Wiring

Note: The branch wiring system is beyond its service life and should be replaced.
