NC School District/080 Bertie County/Middle School

Bertie Middle

Campus Assessment Report

March 8, 2017

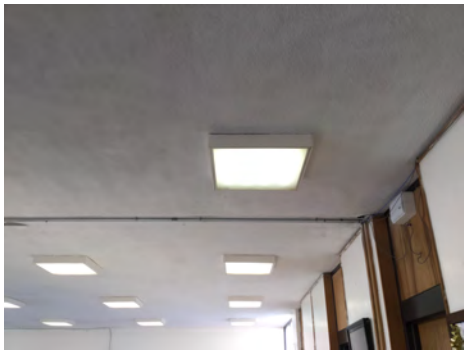
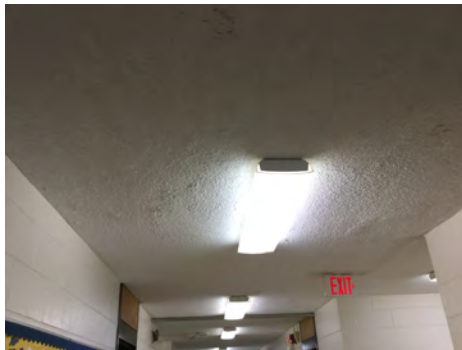
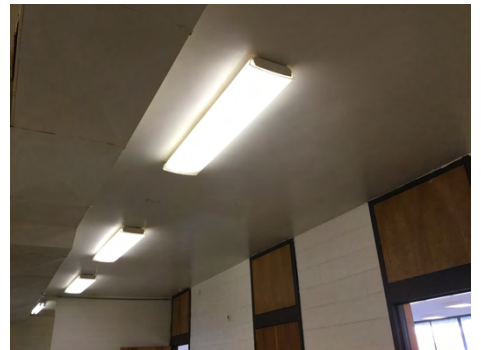
System: D5020 - Lighting

Note: The lighting fixtures are beyond their service life and should be replaced.

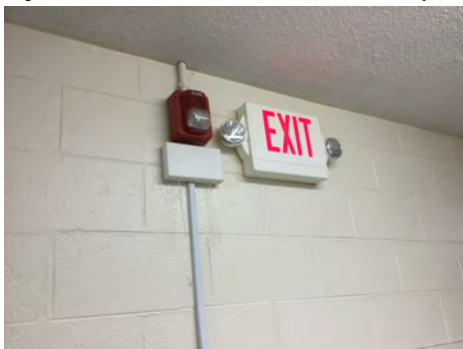
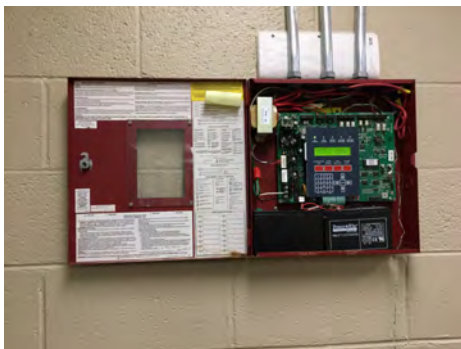
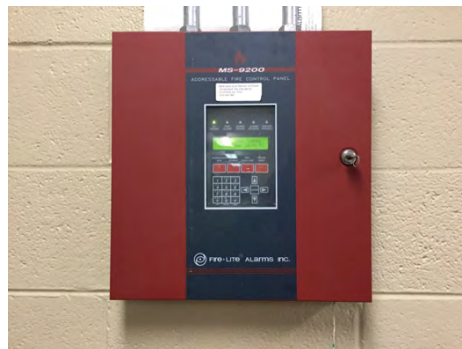
System: D5030910 - Fire & Alarm Systems

Note: The fire alarm system is beyond its service life and should be replaced.

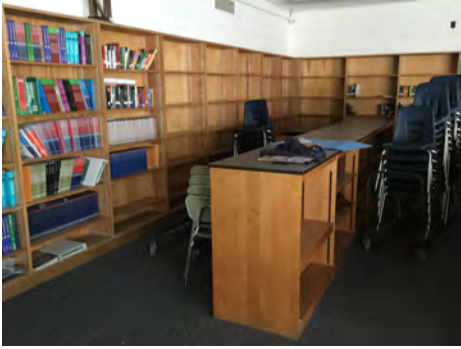
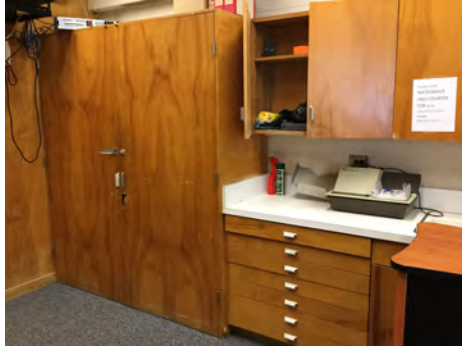
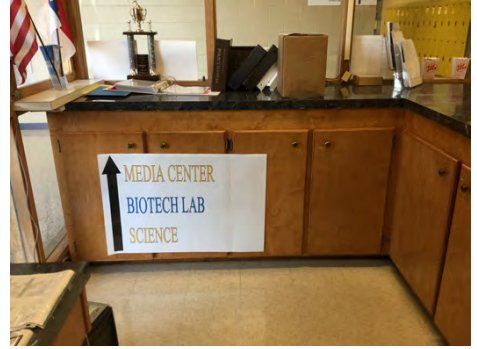
System: E2010 - Fixed Furnishings

Note: The fixed furnishings are beyond their service life and should be replaced.

Notes: The fixed furnishings are beyond their service life and should be replaced.

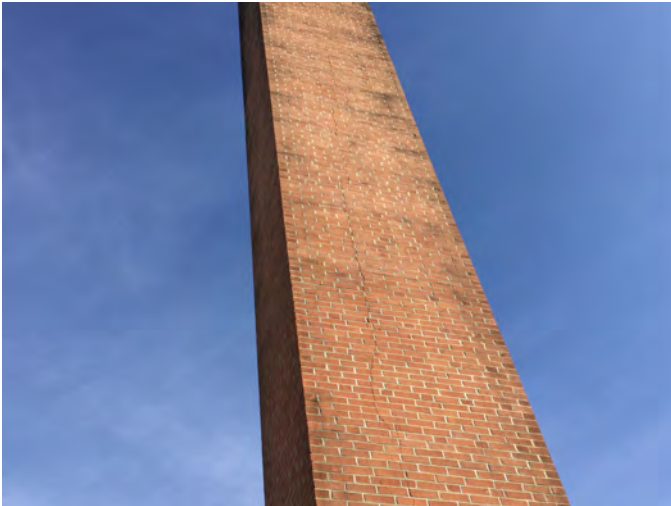
System: B2010 - Exterior Walls

Location: Exterior walls
Distress: Failing
Category: Deferred Maintenance / Safety
Priority: 1 - Currently Critical (Immediate)
Correction: Engineering Study-2016-11-15 17:41:59
Qty: 1.00
Unit of Measure: Ea.
Estimate: \$13,200.00
Assessor Name: Somnath Das
Date Created: 02/03/2017

Notes: The exterior wall has visible cracks on it which should be studied by a professional engineer.

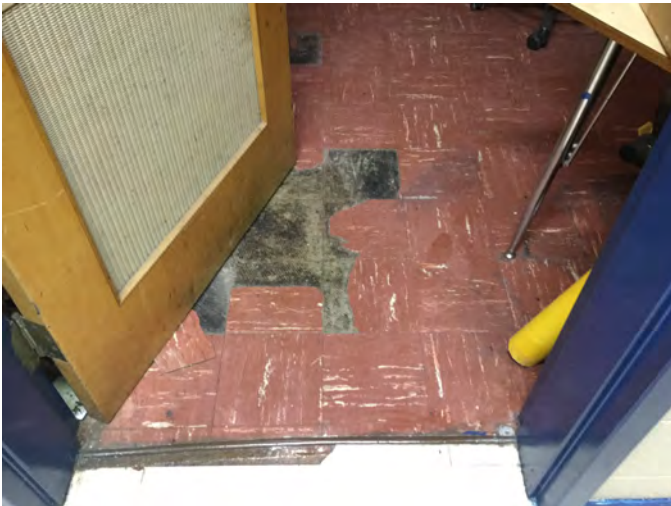
System: C3020 - Floor Finishes

Location: Office Area
Distress: Beyond Service Life
Category: Life Safety Code Compliance
Priority: 1 - Currently Critical (Immediate)
Correction: Replace vinyl tile flooring
Qty: 50.00
Unit of Measure: S.Y.
Estimate: \$6,332.04
Assessor Name: Somnath Das
Date Created: 02/03/2017

Notes: The vinyl tiles in the office area contains suspected material and it should be abated and removed.

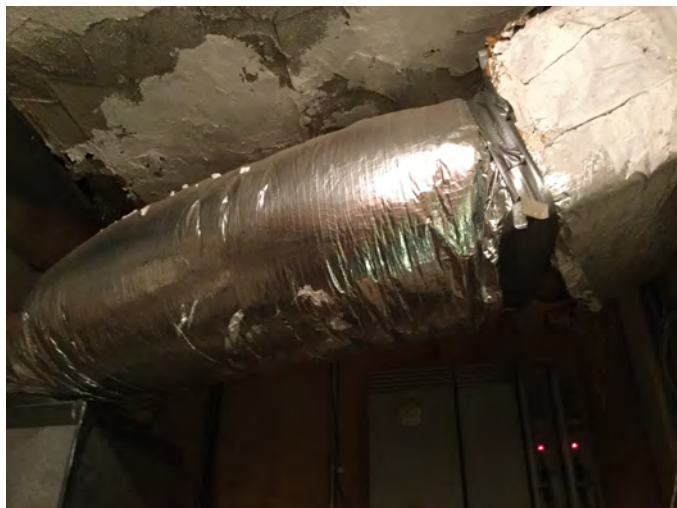
System: D3040 - Distribution Systems

Location: Office area
Distress: Beyond Service Life
Category: Life Safety Code Compliance
Priority: 1 - Currently Critical (Immediate)
Correction: Replace duct insulation
Qty: 150.00
Unit of Measure: S.F.
Estimate: \$5,924.16
Assessor Name: Somnath Das
Date Created: 02/03/2017

Notes: The insulation around the distribution system contains suspected material which should be abated and removed.

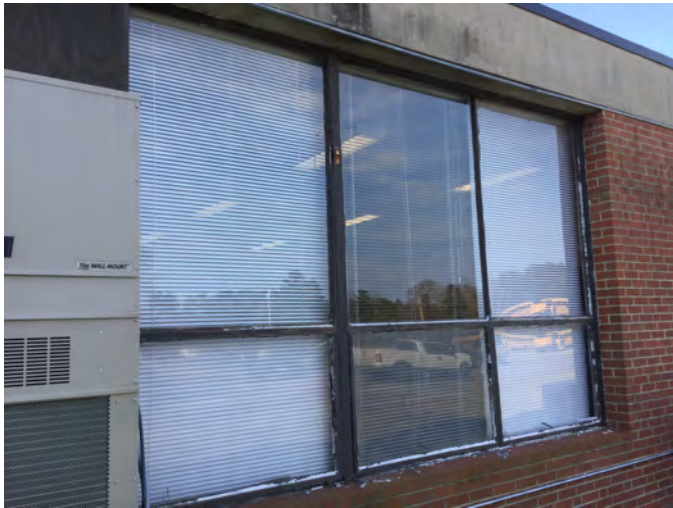
System: B2020 - Exterior Windows

Location: Exterior Walls
Distress: Beyond Service Life
Category: Deferred Maintenance
Priority: 3 - Necessary/Not Yet Critical (Years 2-5)
Correction: Renew System
Qty: 42,892.00
Unit of Measure: S.F.
Estimate: \$615,243.00
Assessor Name: Somnath Das
Date Created: 02/07/2017

Notes: The exterior windows are beyond their service life and should be replaced.

Note: The exterior windows are beyond their service life and should be replaced.

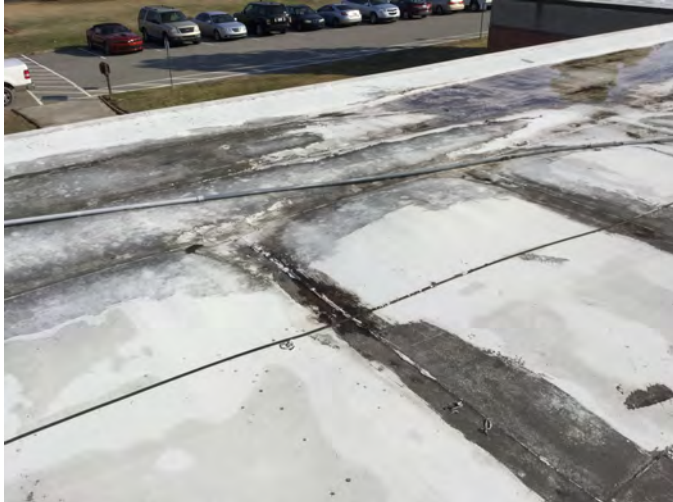
System: B3010120 - Single Ply Membrane

Location: Throughout Building
Distress: Failing
Category: Deferred Maintenance
Priority: 3 - Necessary/Not Yet Critical (Years 2-5)
Correction: Renew System
Qty: 42,892.00
Unit of Measure: S.F.
Estimate: \$449,079.00
Assessor Name: Somnath Das
Date Created: 02/07/2017

Notes: The roof covering is in poor condition and has reported leaks, the roof covering should be replaced.

Note: The roof covering is in poor condition and has reported leaks, the roof covering should be replaced.

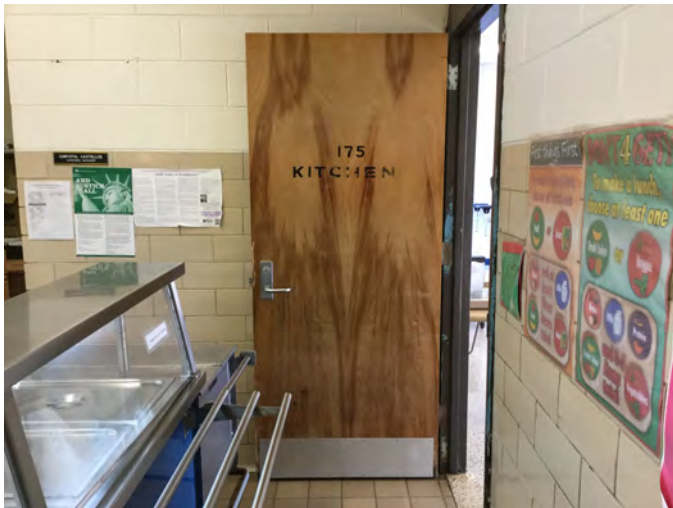
System: C1020 - Interior Doors

Location: Throughout Building
Distress: Beyond Service Life
Category: Deferred Maintenance
Priority: 3 - Necessary/Not Yet Critical (Years 2-5)
Correction: Renew System
Qty: 42,892.00
Unit of Measure: S.F.
Estimate: \$117,481.00
Assessor Name: Somnath Das
Date Created: 02/07/2017

Notes: The interior doors are beyond their service life and should be replaced.

Note: The interior doors are beyond their service life and should be replaced.

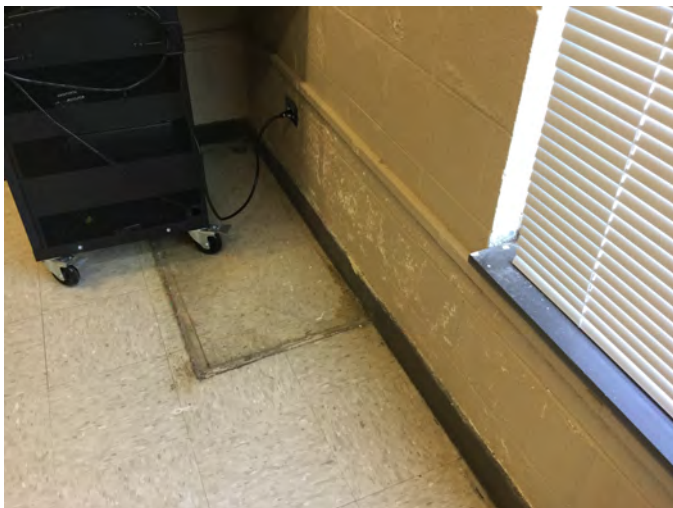
System: C3010 - Wall Finishes

Location: Throughout the building
Distress: Beyond Service Life
Category: Deferred Maintenance / Appearance
Priority: 3 - Necessary/Not Yet Critical (Years 2-5)
Correction: Repaint the walls
Qty: 15,000.00
Unit of Measure: S.F.
Estimate: \$19,800.00
Assessor Name: Somnath Das
Date Created: 02/03/2017

Notes: The classrooms wall finishes are beyond their service life and should be replaced.

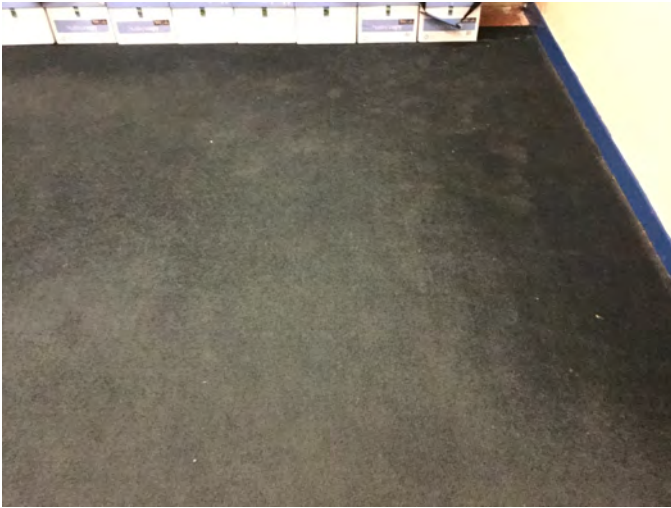
System: C3020 - Floor Finishes

Location: Classroom, Media Center, and Office
Distress: Beyond Service Life
Category: Deferred Maintenance
Priority: 3 - Necessary/Not Yet Critical (Years 2-5)
Correction: Replace carpet
Qty: 150.00
Unit of Measure: S.Y.
Estimate: \$12,822.48
Assessor Name: Somnath Das
Date Created: 02/03/2017

Notes: The carpet is beyond its service life and should be replaced.

Note: Carpet needs to be replaced.

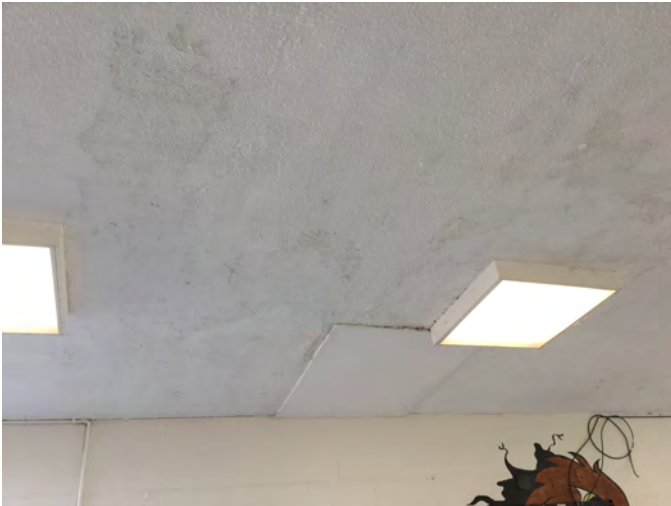
System: C3030 - Ceiling Finishes

Location: Throughout Building
Distress: Beyond Service Life
Category: Deferred Maintenance
Priority: 3 - Necessary/Not Yet Critical (Years 2-5)
Correction: Renew System
Qty: 42,892.00
Unit of Measure: S.F.
Estimate: \$508,142.00
Assessor Name: Somnath Das
Date Created: 02/07/2017

Notes: The ceiling finishes are beyond their service life and should be replaced.

Note: The ceiling finishes are beyond their service life and should be replaced.

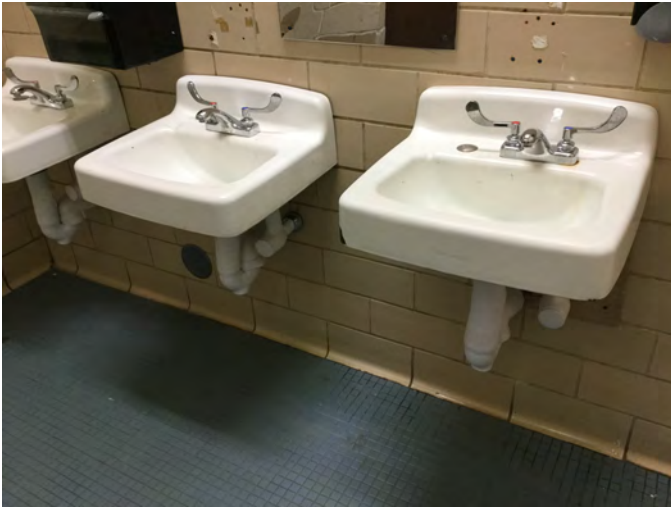
System: D2010 - Plumbing Fixtures

Location: Throughout Building
Distress: Beyond Service Life
Category: Deferred Maintenance
Priority: 3 - Necessary/Not Yet Critical (Years 2-5)
Correction: Renew System
Qty: 42,892.00
Unit of Measure: S.F.
Estimate: \$425,574.00
Assessor Name: Somnath Das
Date Created: 02/07/2017

Notes: The plumbing fixtures are beyond their service life and should be replaced.

Note: The plumbing fixtures are beyond their service life and should be replaced.

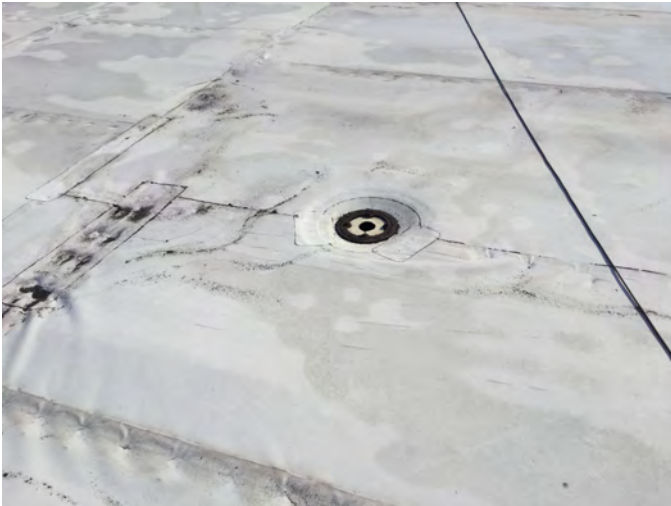
System: D2040 - Rain Water Drainage

Location: Roof
Distress: Beyond Service Life
Category: Deferred Maintenance
Priority: 3 - Necessary/Not Yet Critical (Years 2-5)
Correction: Renew System
Qty: 42,892.00
Unit of Measure: S.F.
Estimate: \$30,668.00
Assessor Name: Somnath Das
Date Created: 02/07/2017

Notes: The roof drainage system is beyond its service life and should be replaced.

Note: The roof drainage system is beyond its service life and should be replaced.

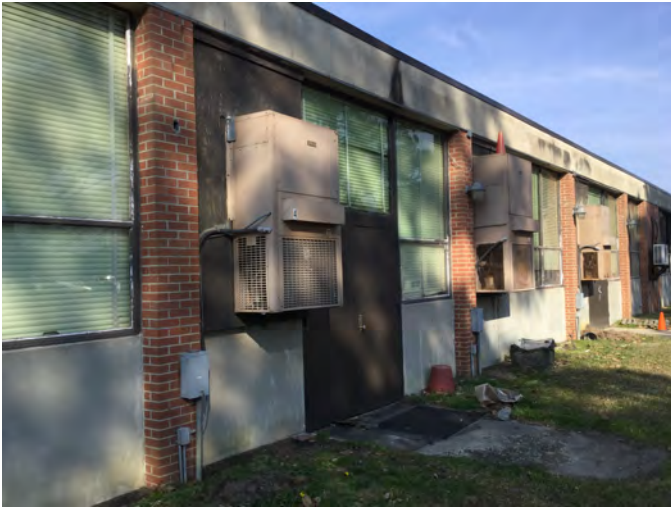
System: D3050 - Terminal & Package Units

Location: Exterior walls
Distress: Beyond Service Life
Category: Deferred Maintenance
Priority: 3 - Necessary/Not Yet Critical (Years 2-5)
Correction: Replace heat pump, thru-wall unit, 1.5 ton
Qty: 6.00
Unit of Measure: Ea.
Estimate: \$44,312.40
Assessor Name: Somnath Das
Date Created: 02/03/2017

Notes: The terminal and package units are beyond their service life and should be replaced.

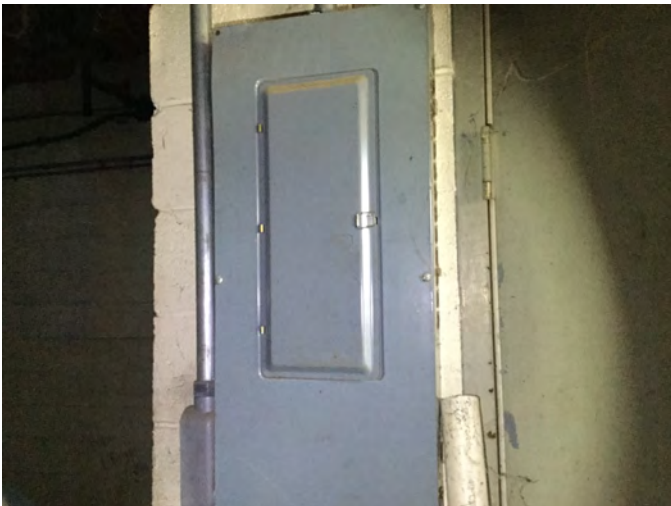
System: D5020 - Branch Wiring

Location: Throughout Building
Distress: Beyond Service Life
Category: Deferred Maintenance
Priority: 3 - Necessary/Not Yet Critical (Years 2-5)
Correction: Renew System
Qty: 42,892.00
Unit of Measure: S.F.
Estimate: \$219,393.00
Assessor Name: Somnath Das
Date Created: 02/07/2017

Notes: The branch wiring system is beyond its service life and should be replaced.

Note: The branch wiring system is beyond its service life and should be replaced.

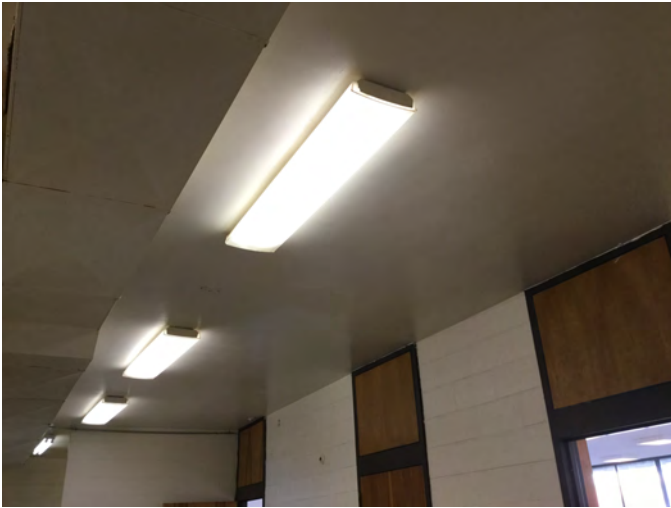
System: D5020 - Lighting

Location: Throughout Building
Distress: Beyond Service Life
Category: Deferred Maintenance
Priority: 3 - Necessary/Not Yet Critical (Years 2-5)
Correction: Renew System
Qty: 42,892.00
Unit of Measure: S.F.
Estimate: \$511,916.00
Assessor Name: Somnath Das
Date Created: 02/07/2017

Notes: The lighting fixtures are beyond their service life and should be replaced.

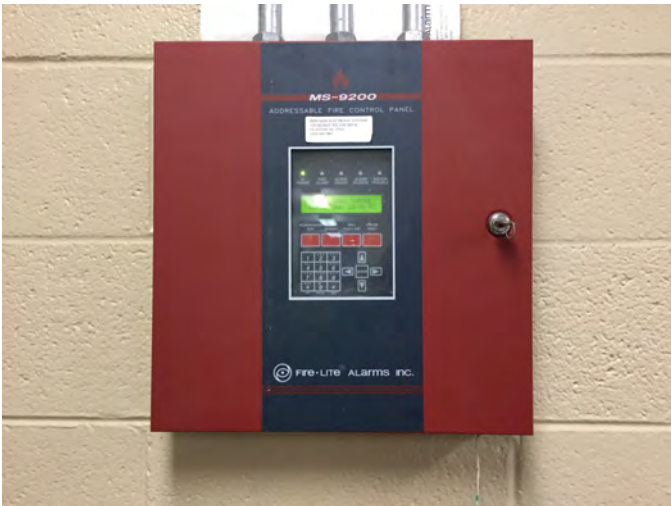
System: D5030910 - Fire & Alarm Systems

Location: Throughout Building
Distress: Beyond Service Life
Category: Deferred Maintenance
Priority: 3 - Necessary/Not Yet Critical (Years 2-5)
Correction: Renew System
Qty: 42,892.00
Unit of Measure: S.F.
Estimate: \$171,740.00
Assessor Name: Somnath Das
Date Created: 02/07/2017

Notes: The fire alarm system is beyond its service life and should be replaced.

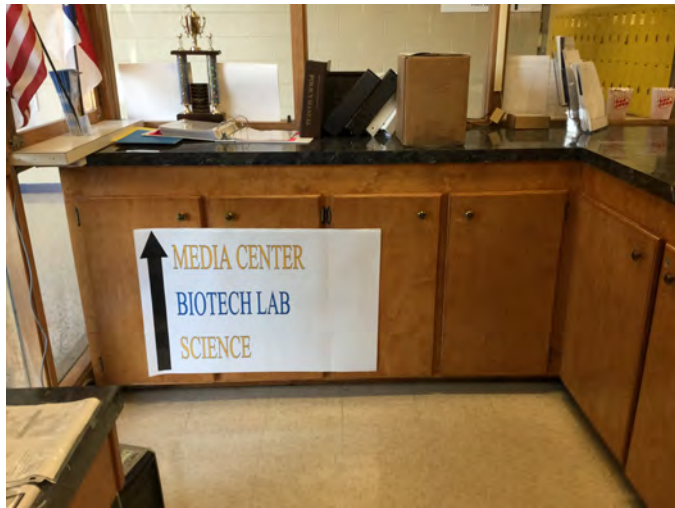
System: E2010 - Fixed Furnishings

Location: Throughout Building
Distress: Beyond Service Life
Category: Deferred Maintenance
Priority: 3 - Necessary/Not Yet Critical (Years 2-5)
Correction: Renew System
Qty: 42,892.00
Unit of Measure: S.F.
Estimate: \$239,681.00
Assessor Name: Somnath Das
Date Created: 02/07/2017

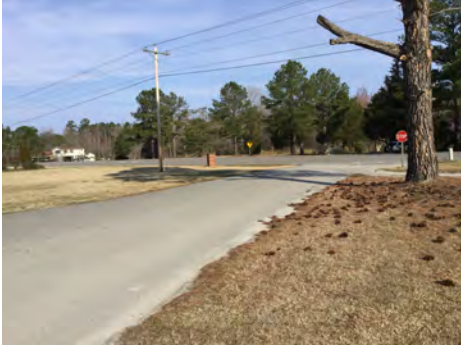
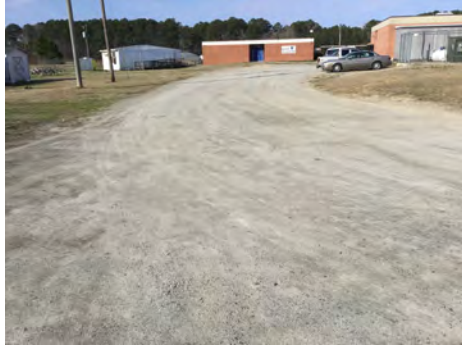
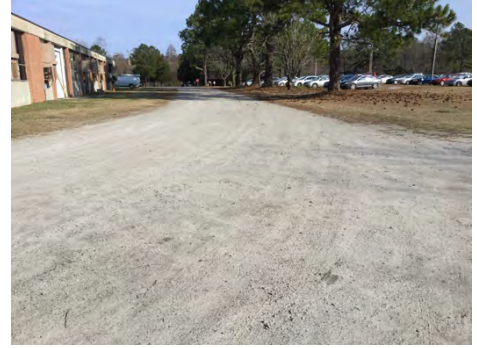
System: G2010 - Roadways

Note: The roadways are loose gravel and they should be replaced.

Location: Site
Distress: Inadequate
Category: Deferred Maintenance
Priority: 3 - Necessary/Not Yet Critical (Years 2-5)
Correction: Renew System
Qty: 64,407.00
Unit of Measure: S.F.
Estimate: \$266,387.00
Assessor Name: Eduardo Lopez
Date Created: 02/07/2017

Notes: The roadways are loose gravel and they should be replaced.

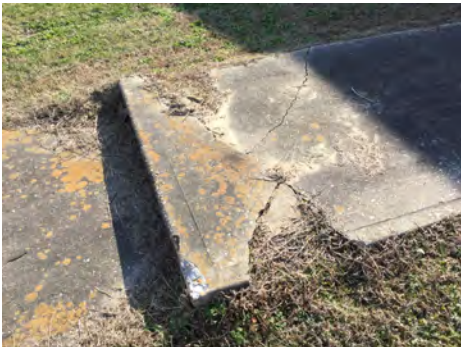
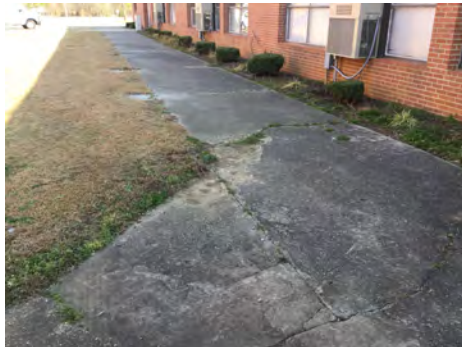
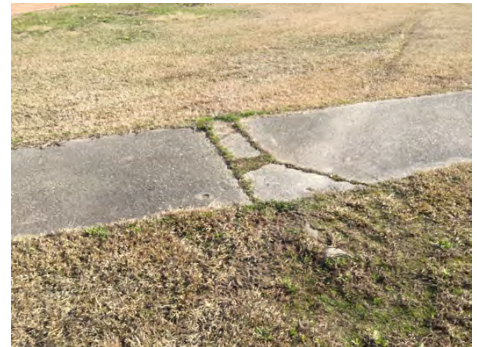
System: G2030 - Pedestrian Paving

Note: The pedestrian paving is cracked and beyond its service life and should be replaced.

Notes: The pedestrian paving is cracked and beyond its service life and should be replaced.

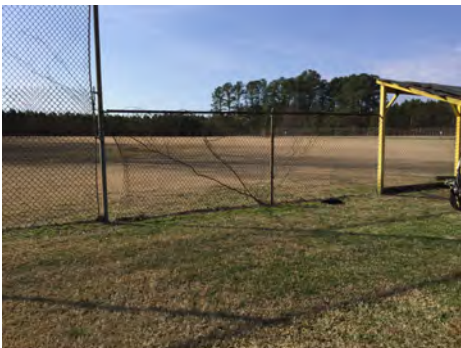
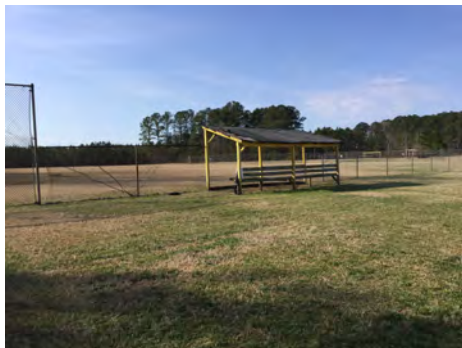
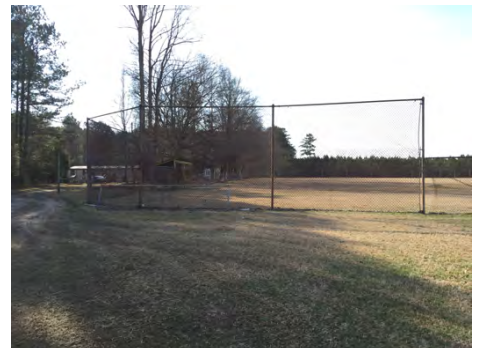
System: G2040105 - Fence & Guardrails

Note: The fences and guardrails are beyond their service life and should be replaced.

Notes: The fences and guardrails are beyond their service life and should be replaced.

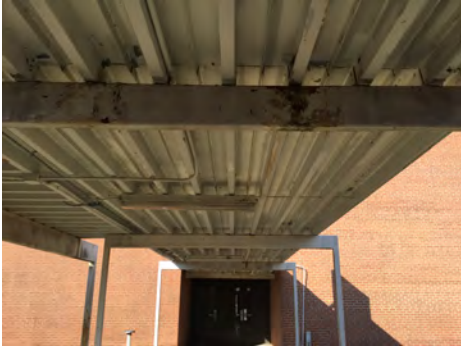
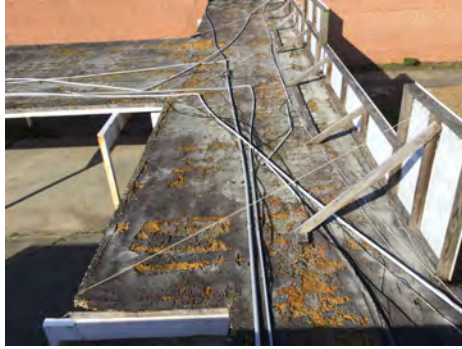
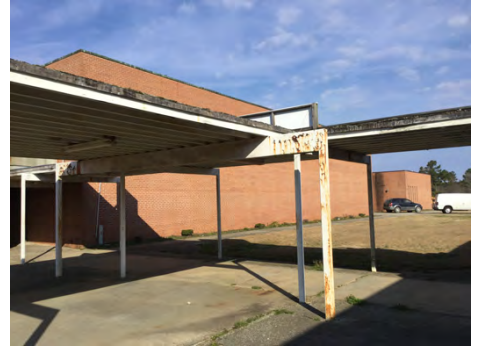
System: G2040950 - Covered Walkways

Note: The covered walkways are beyond their service life and should be replaced.

Notes: The covered walkways are beyond their service life and should be replaced.

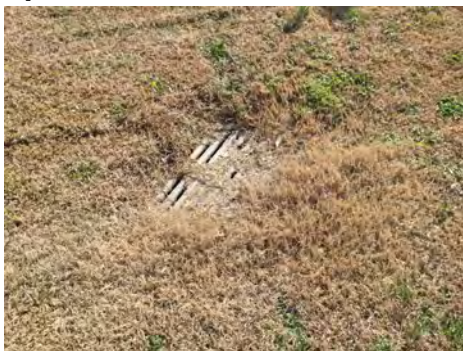
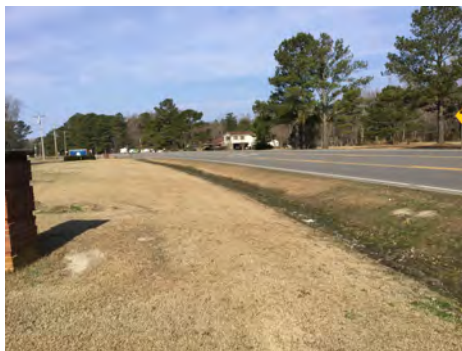
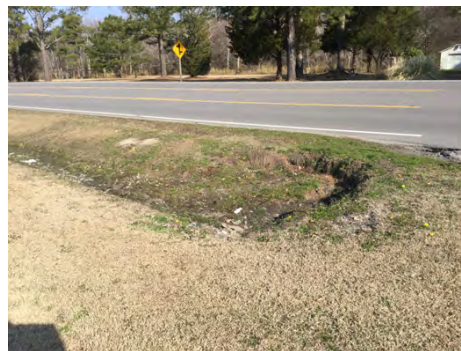
System: G3030 - Storm Sewer

Note: The storm sewer system is inadequate and should be replaced.

Notes: The storm sewer system is inadequate and should be replaced.

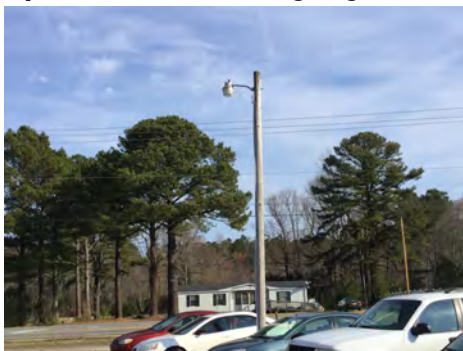
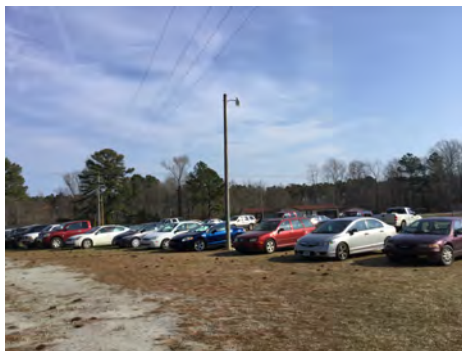
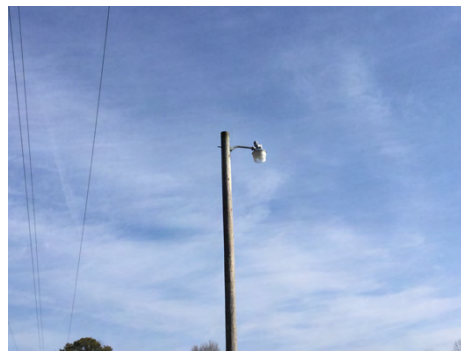
System: G4020 - Site Lighting

Note: The site lighting is beyond its service life and should be replaced.

Notes: The site lighting is beyond its service life and should be replaced.

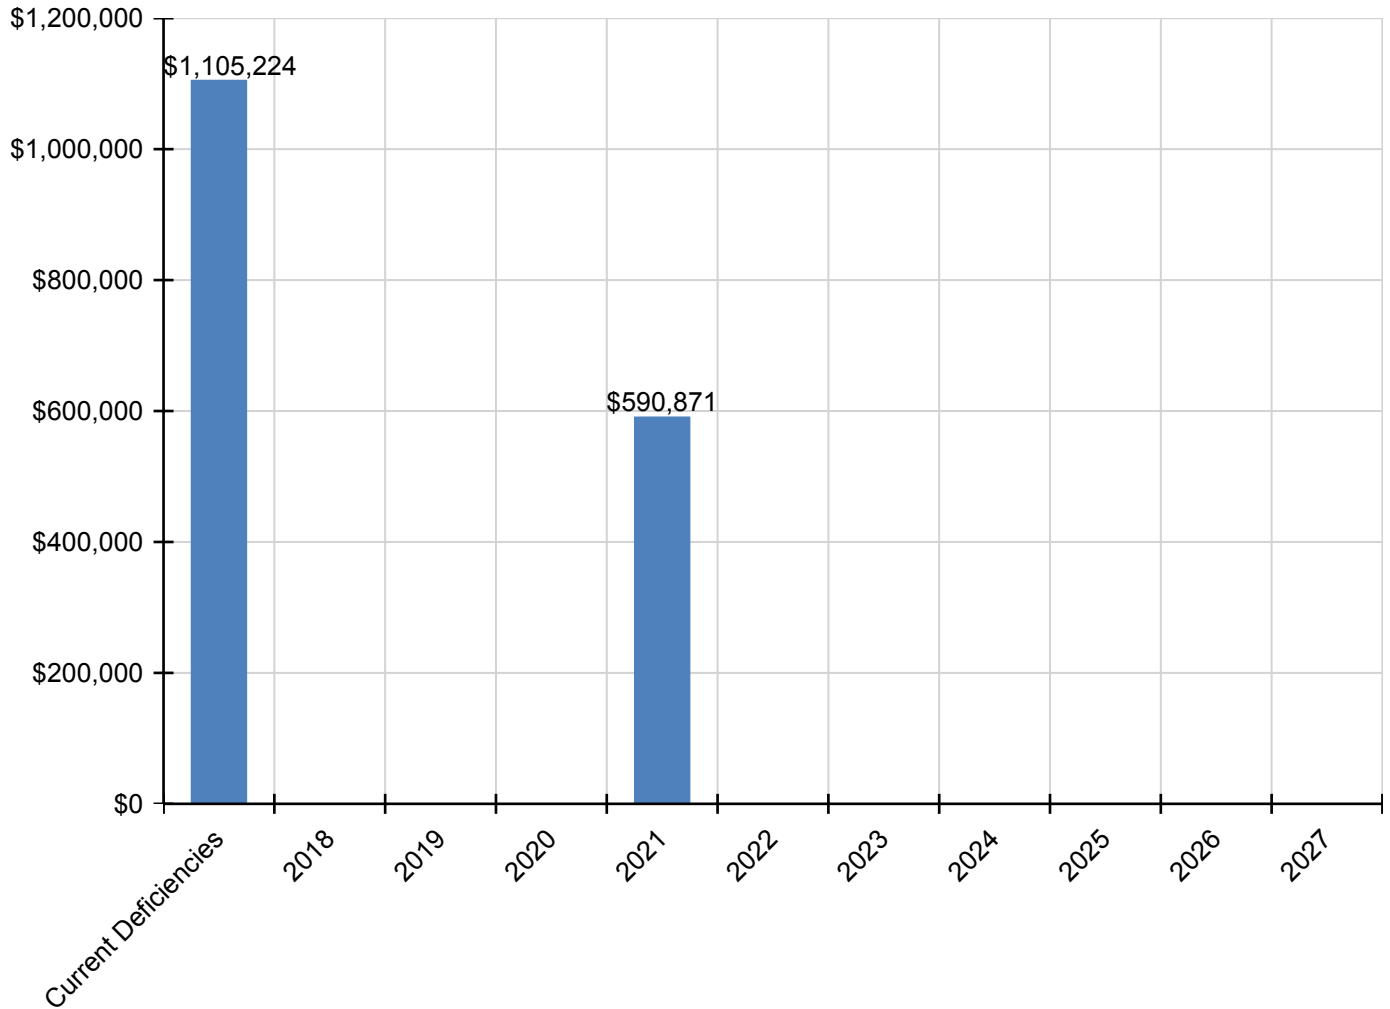
Forecasted Capital Renewal Requirement

The following chart shows the current building deficiencies and forecasting capital renewal or sustainment requirements over the next ten years.

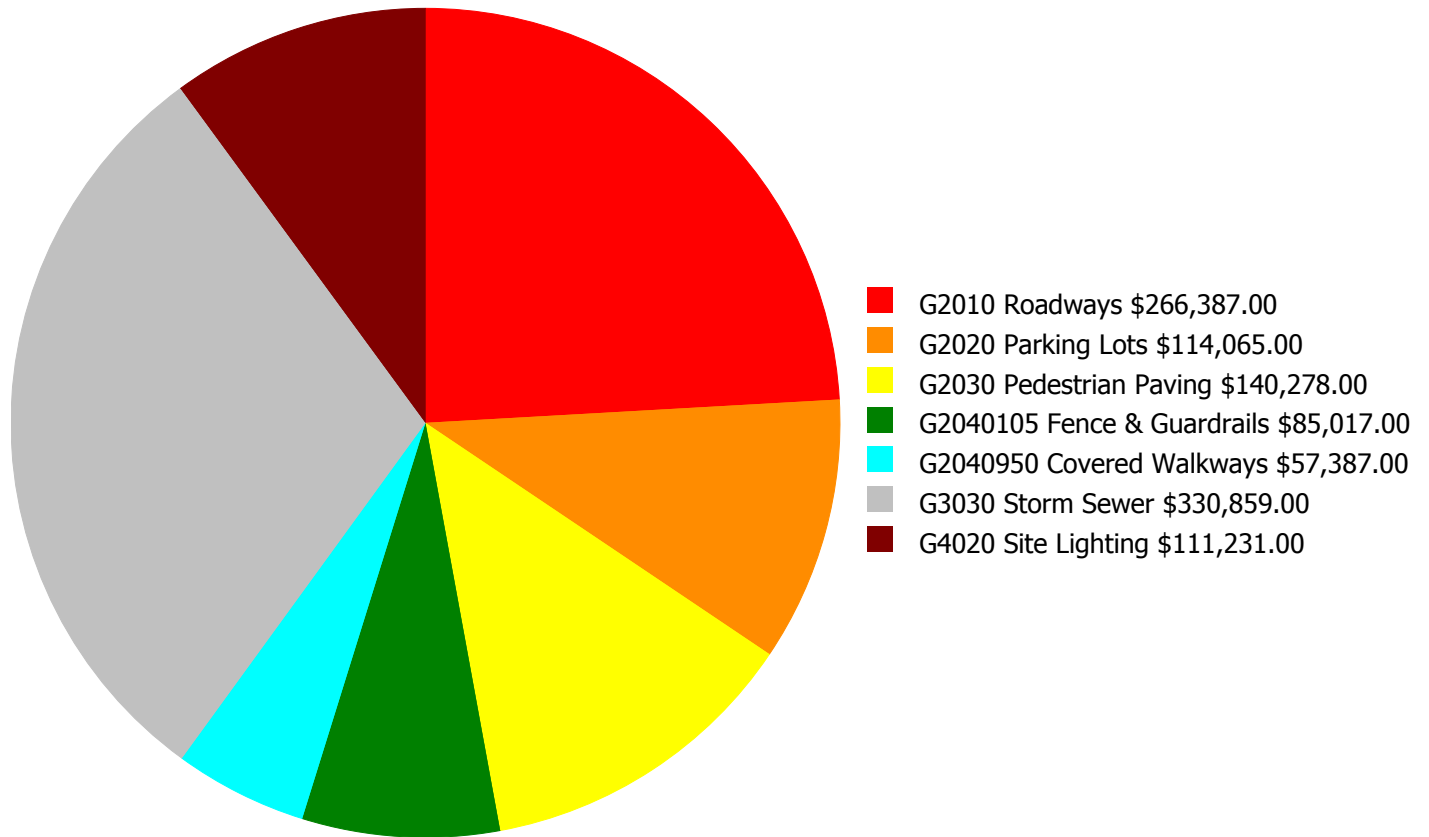
Deficiency Summary by System

Current deficiencies included assemblies that have reached or exceeded their design life or components of the assemblies that are in need of repair. Assemblies that have reached their design life are identified as current deficiencies and assigned the distress 'Beyond Useful Life'. The following chart lists all current deficiencies associated with this facility.

Budget Estimate Total: \$1,105,224.00

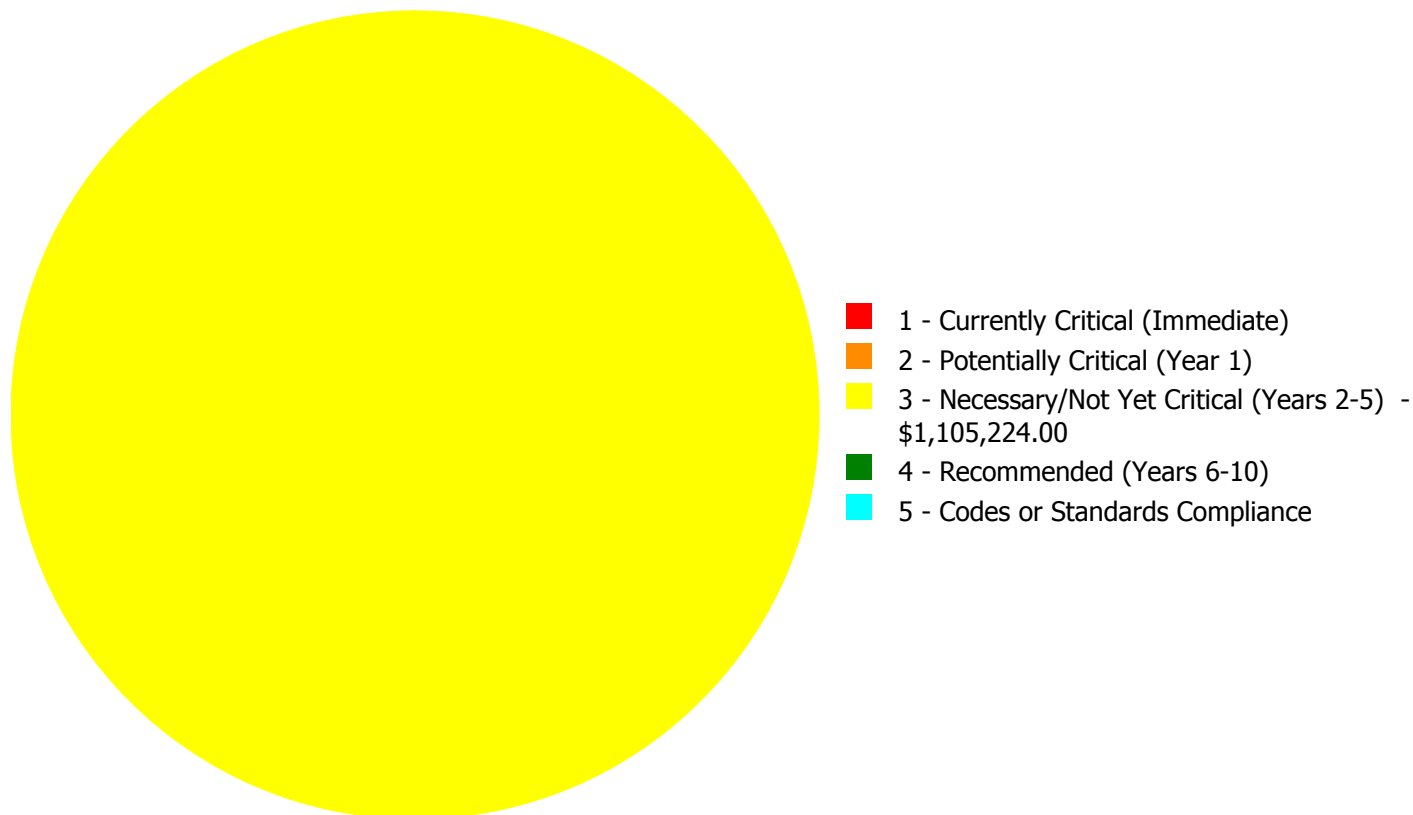
Deficiency Summary by Priority

The following chart shows the total repair costs broken down by priority. Assessors assigned deficiencies within eCOMET to one of the following priority categories:

Budget Estimate Total: \$1,105,224.00

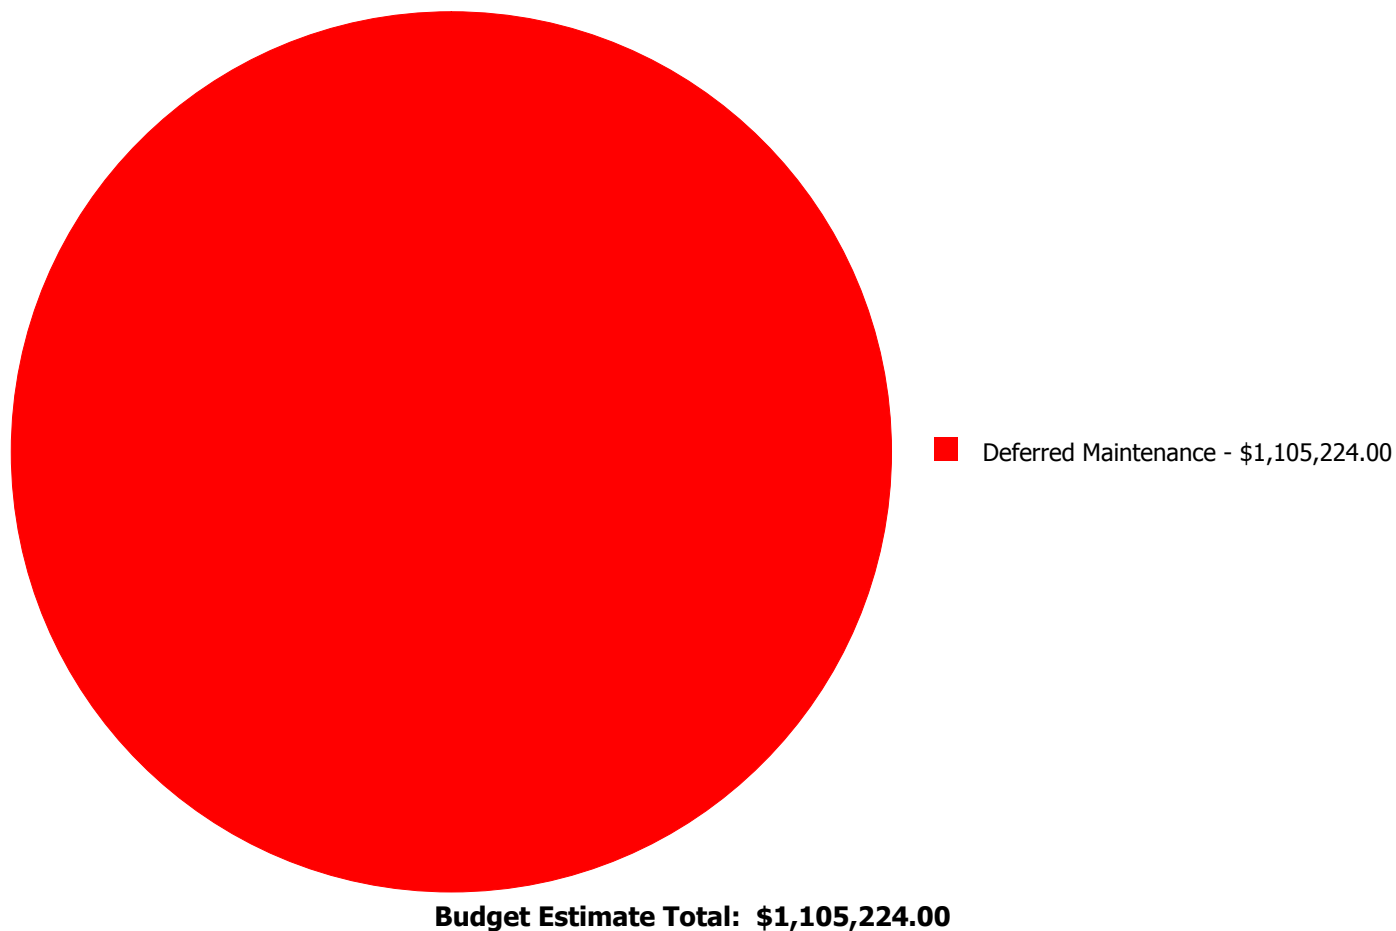
Deficiency Summary by Category

The following chart shows the total repair costs broken down by deficiency categories. Assessors assigned deficiencies to one of the following categories:

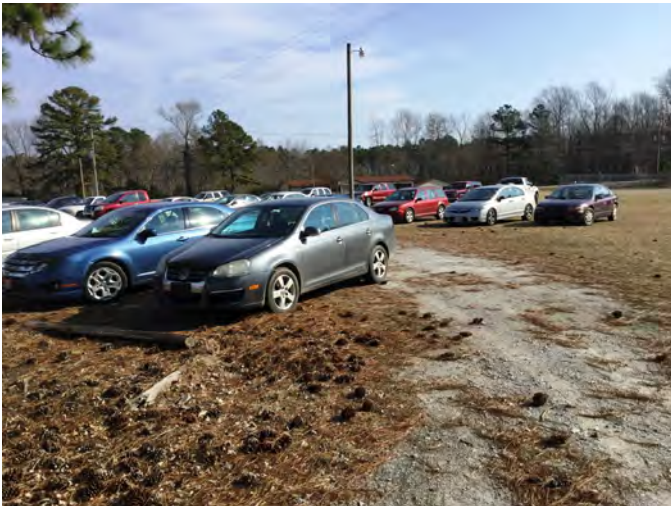
System: G2020 - Parking Lots

Location: Site
Distress: Inadequate
Category: Deferred Maintenance
Priority: 3 - Necessary/Not Yet Critical (Years 2-5)
Correction: Renew System
Qty: 64,407.00
Unit of Measure: S.F.
Estimate: \$114,065.00
Assessor Name: Eduardo Lopez
Date Created: 02/07/2017

Notes: The parking lots are inadequate and not properly designated and they should be replaced.

Note: The parking lots are inadequate and not properly designated and they should be replaced.

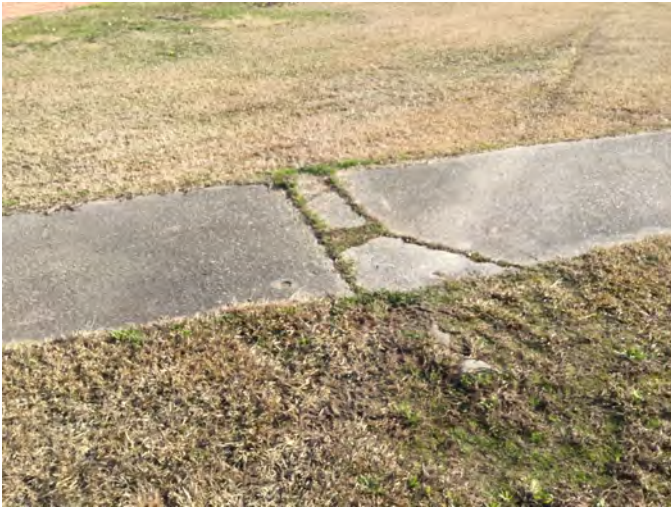
System: G2030 - Pedestrian Paving

Location: Site
Distress: Failing
Category: Deferred Maintenance
Priority: 3 - Necessary/Not Yet Critical (Years 2-5)
Correction: Renew System
Qty: 64,407.00
Unit of Measure: S.F.
Estimate: \$140,278.00
Assessor Name: Eduardo Lopez
Date Created: 02/07/2017

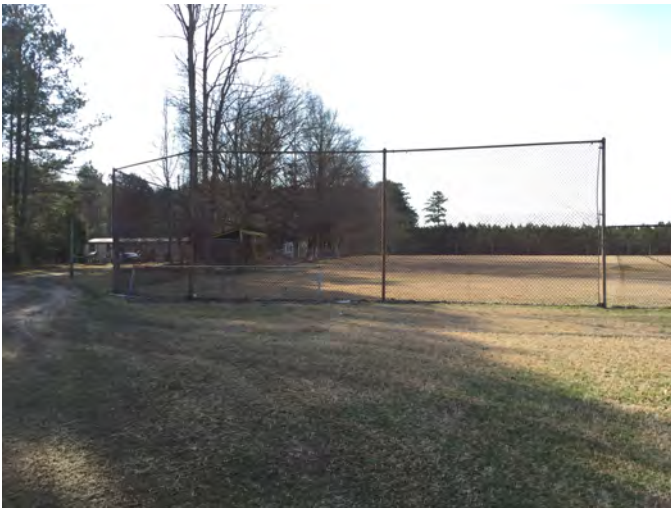
System: G2040105 - Fence & Guardrails

Location: Site
Distress: Beyond Service Life
Category: Deferred Maintenance
Priority: 3 - Necessary/Not Yet Critical (Years 2-5)
Correction: Renew System
Qty: 64,407.00
Unit of Measure: S.F.
Estimate: \$85,017.00
Assessor Name: Eduardo Lopez
Date Created: 02/07/2017

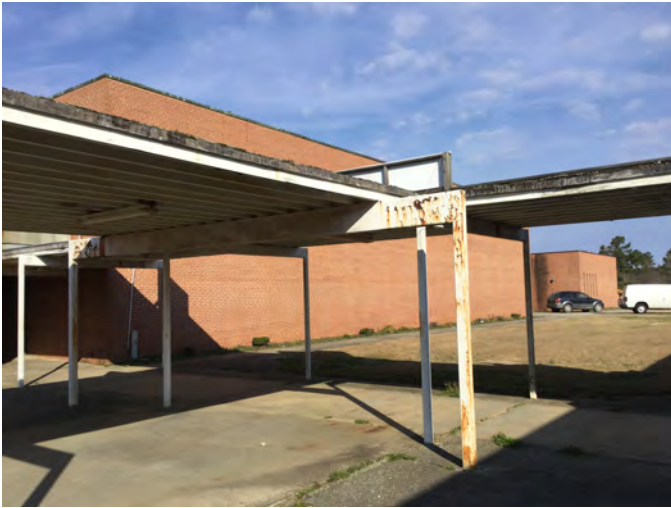
System: G2040950 - Covered Walkways

Location: Site
Distress: Beyond Service Life
Category: Deferred Maintenance
Priority: 3 - Necessary/Not Yet Critical (Years 2-5)
Correction: Renew System
Qty: 64,407.00
Unit of Measure: S.F.
Estimate: \$57,387.00
Assessor Name: Eduardo Lopez
Date Created: 02/07/2017

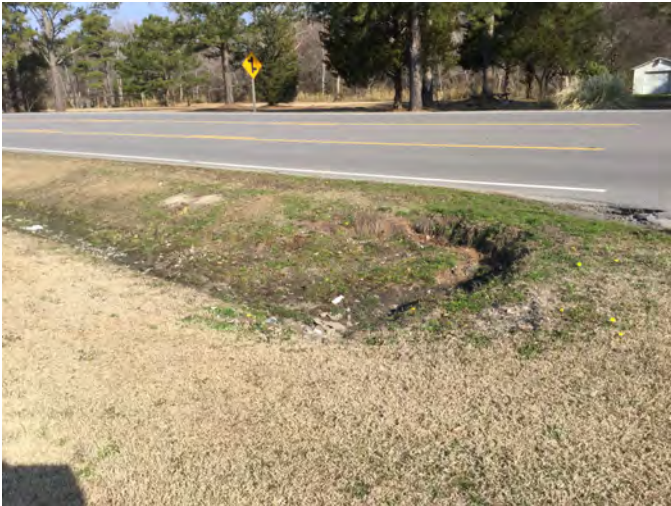
System: G3030 - Storm Sewer

Location: Site
Distress: Inadequate
Category: Deferred Maintenance
Priority: 3 - Necessary/Not Yet Critical (Years 2-5)
Correction: Renew System
Qty: 64,407.00
Unit of Measure: S.F.
Estimate: \$330,859.00
Assessor Name: Eduardo Lopez
Date Created: 02/07/2017

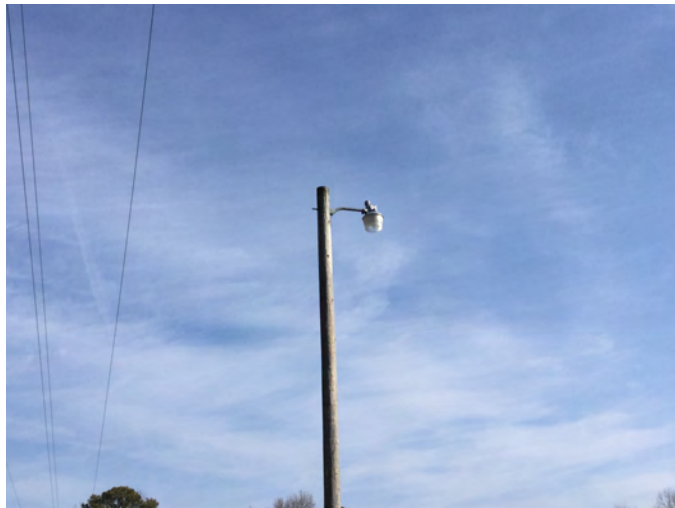
System: G4020 - Site Lighting

Location: Site
Distress: Inadequate
Category: Deferred Maintenance
Priority: 3 - Necessary/Not Yet Critical (Years 2-5)
Correction: Renew System
Qty: 64,407.00
Unit of Measure: S.F.
Estimate: \$111,231.00
Assessor Name: Eduardo Lopez
Date Created: 02/07/2017

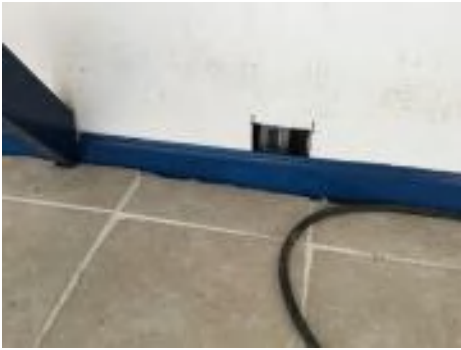
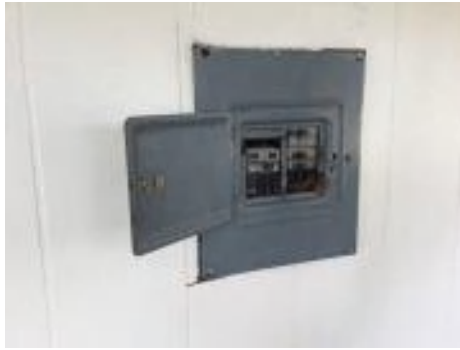
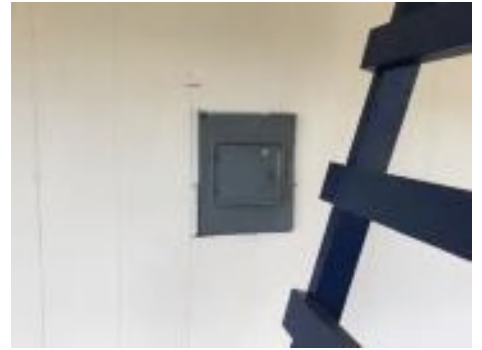
System: D5010 - Electrical Service/Distribution

Note: The electrical distribution system is beyond its service life and should be replaced.

Notes: The electrical distribution system is beyond its service life and should be replaced.

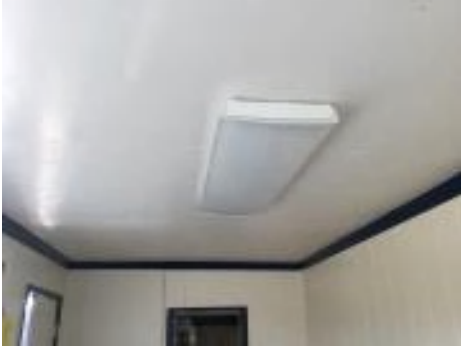
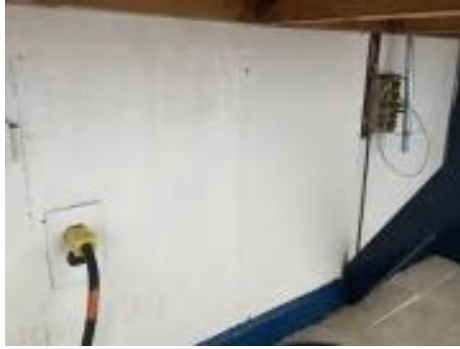
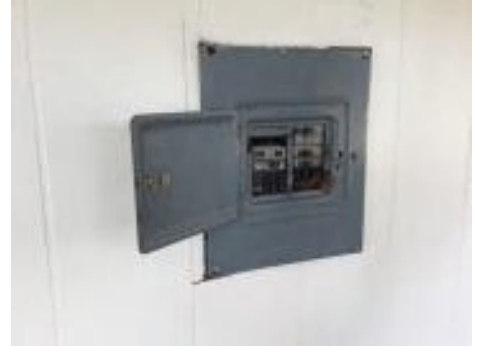
System: D5020 - Branch Wiring

Note: The branch wiring system is beyond its service life and should be replaced.

Notes: The branch wiring system is beyond its service life and should be replaced.

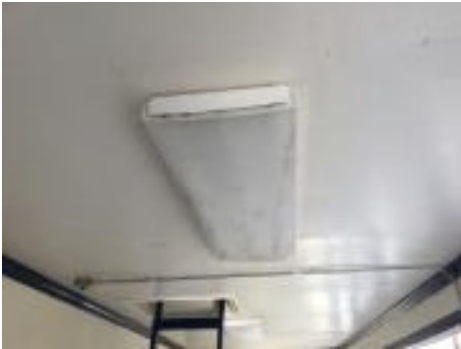
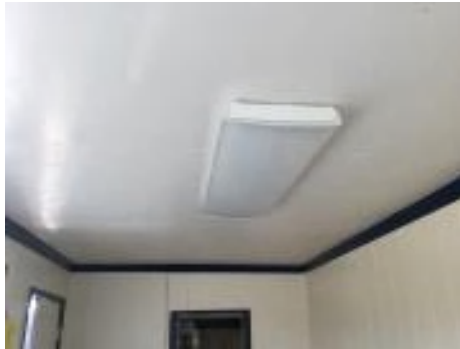
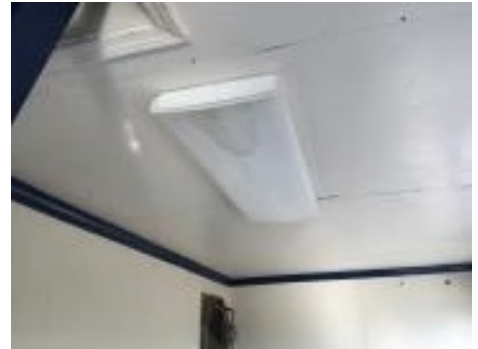
System: D5020 - Lighting

Note: The lighting system is beyond its service life and should be replaced.

Notes: The lighting system is beyond its service life and should be replaced.
