NC School District/080 Bertie County/Middle School

Bertie Middle

Campus Assessment Report

March 8, 2017

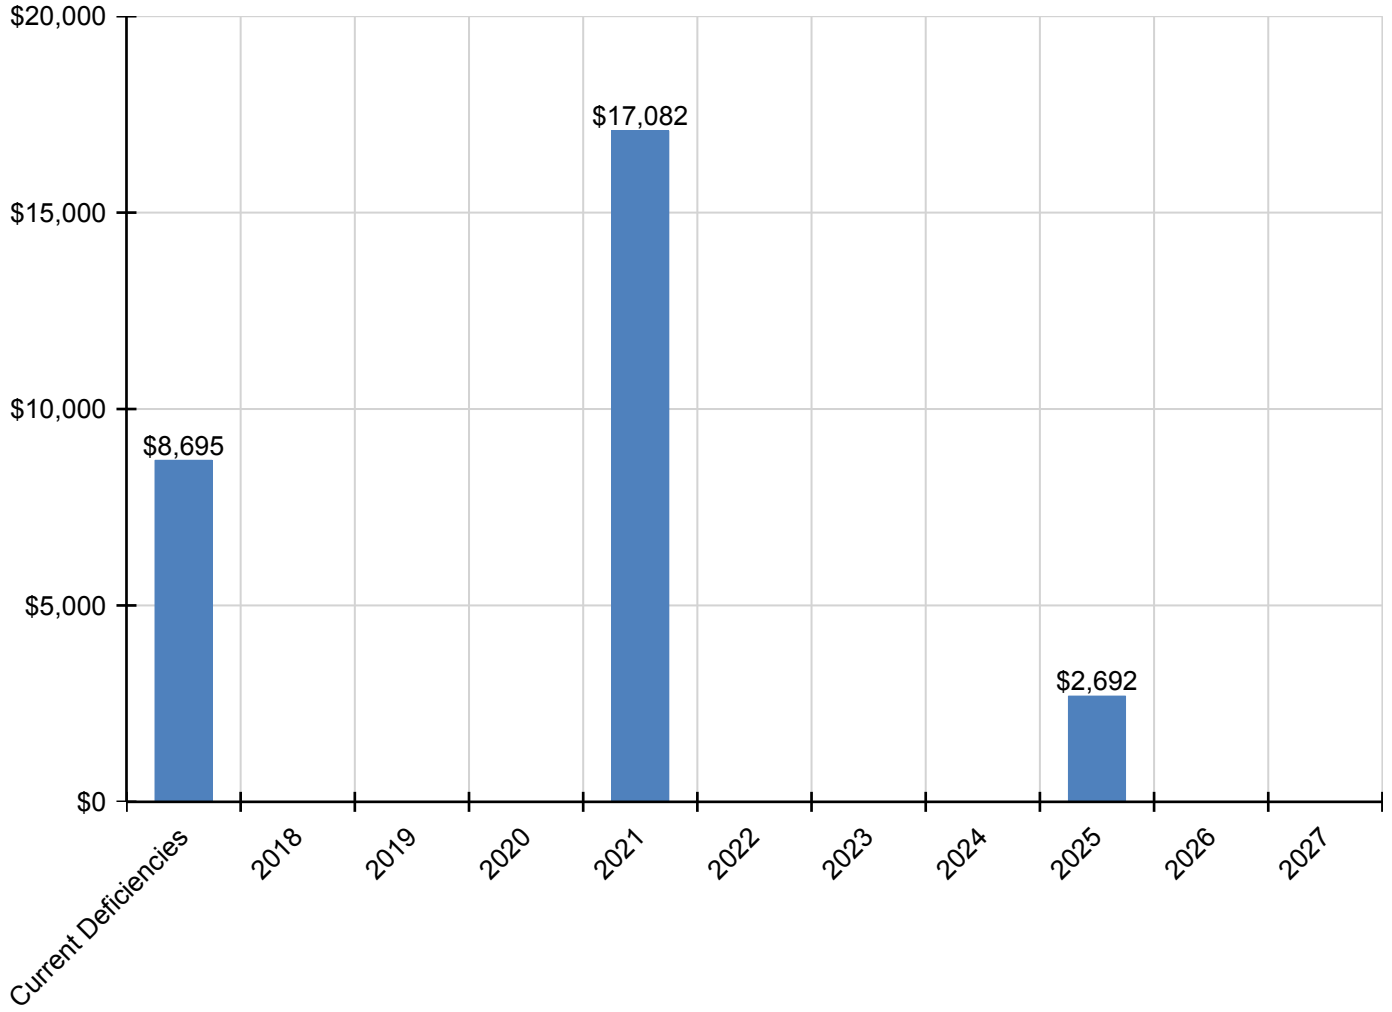
Forecasted Capital Renewal Requirement

The following chart shows the current building deficiencies and forecasting capital renewal or sustainment requirements over the next ten years.

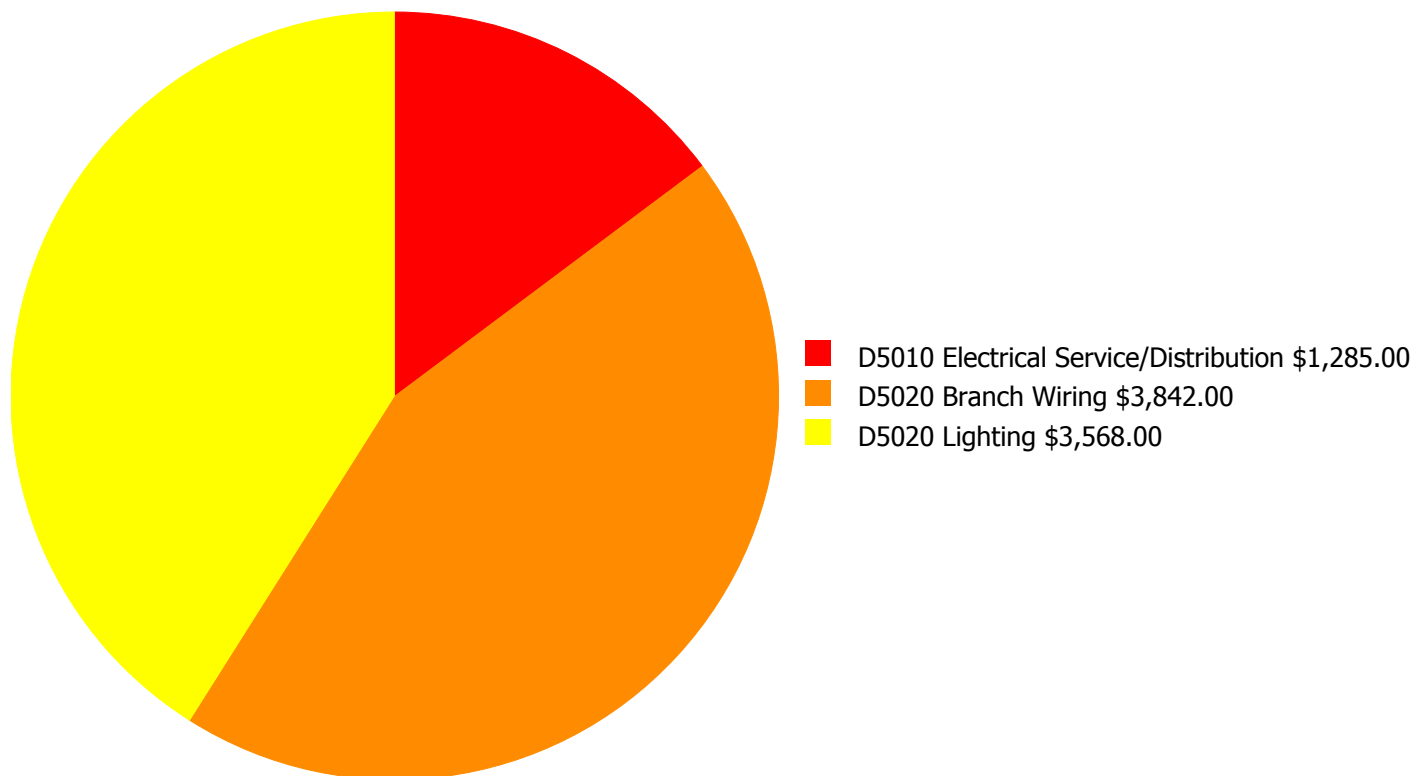
Deficiency Summary by System

Current deficiencies included assemblies that have reached or exceeded their design life or components of the assemblies that are in need of repair. Assemblies that have reached their design life are identified as current deficiencies and assigned the distress 'Beyond Useful Life'. The following chart lists all current deficiencies associated with this facility.

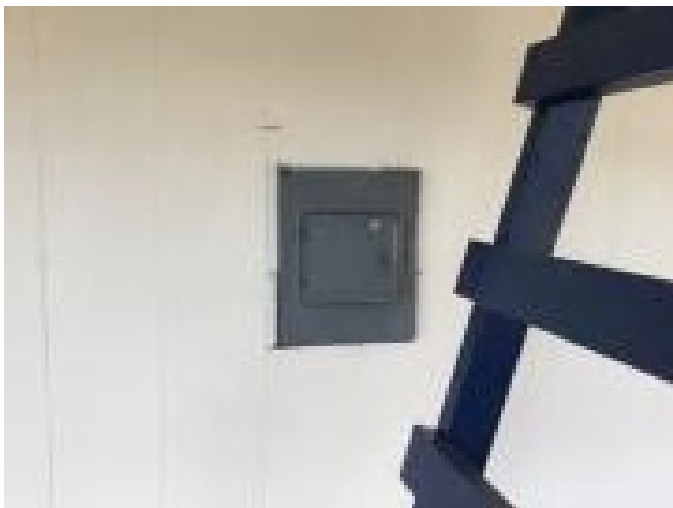
System: D5010 - Electrical Service/Distribution

Location: Throughout Building
Distress: Beyond Service Life
Category: Deferred Maintenance
Priority: 3 - Necessary/Not Yet Critical (Years 2-5)
Correction: Renew System
Qty: 378.00
Unit of Measure: S.F.
Estimate: \$1,285.00
Assessor Name: Eduardo Lopez
Date Created: 02/07/2017

Notes: The electrical distribution system is beyond its service life and should be replaced.

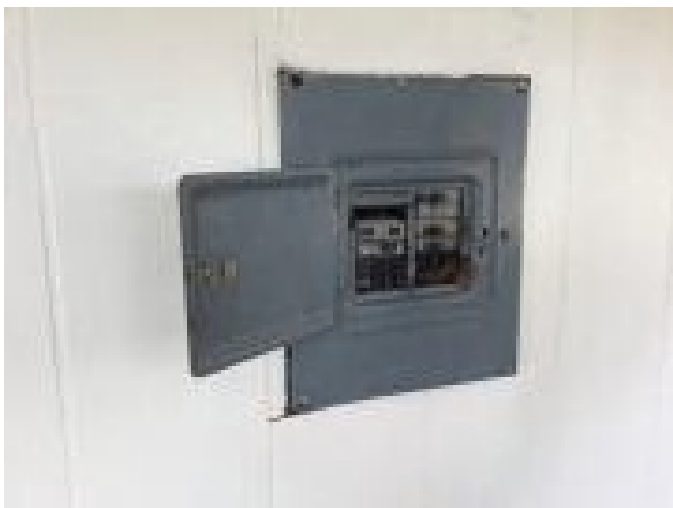
System: D5020 - Branch Wiring

Location: Throughout Building
Distress: Beyond Service Life
Category: Deferred Maintenance
Priority: 3 - Necessary/Not Yet Critical (Years 2-5)
Correction: Renew System
Qty: 378.00
Unit of Measure: S.F.
Estimate: \$3,842.00
Assessor Name: Eduardo Lopez
Date Created: 02/07/2017

Notes: The branch wiring system is beyond its service life and should be replaced.

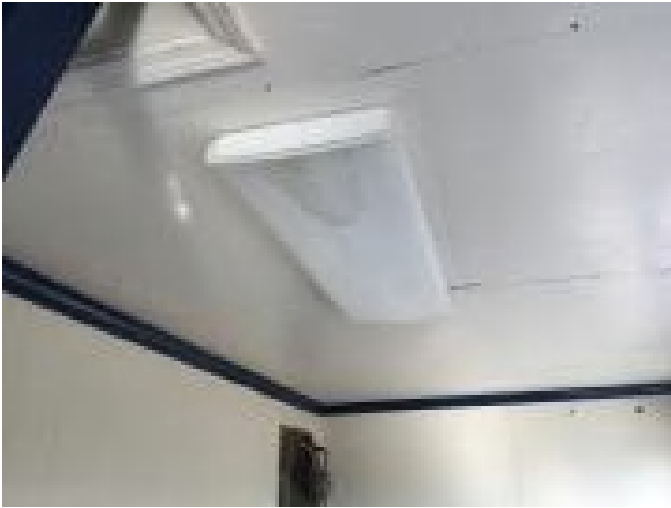
System: D5020 - Lighting

Location: Throughout Building
Distress: Beyond Service Life
Category: Deferred Maintenance
Priority: 3 - Necessary/Not Yet Critical (Years 2-5)
Correction: Renew System
Qty: 378.00
Unit of Measure: S.F.
Estimate: \$3,568.00
Assessor Name: Eduardo Lopez
Date Created: 02/07/2017

Notes: The lighting system is beyond its service life and should be replaced.

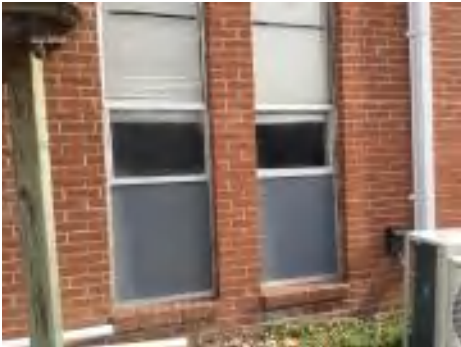
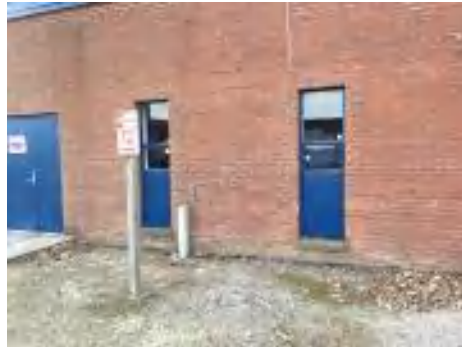
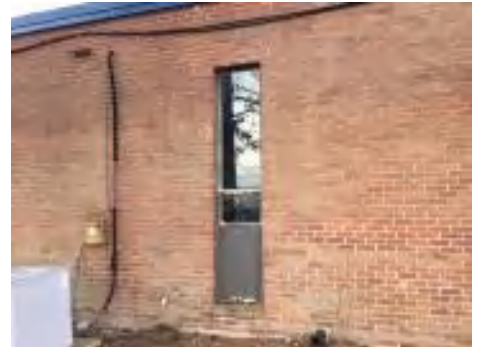
System: B2020 - Exterior Windows

Note: The exterior windows are beyond their service life and should be replaced.

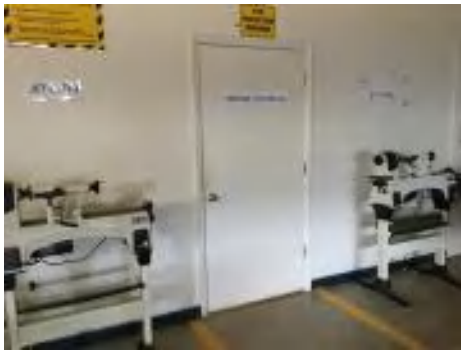
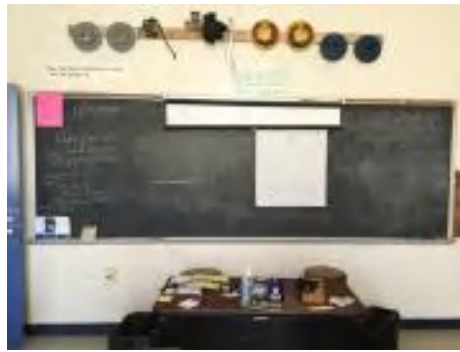
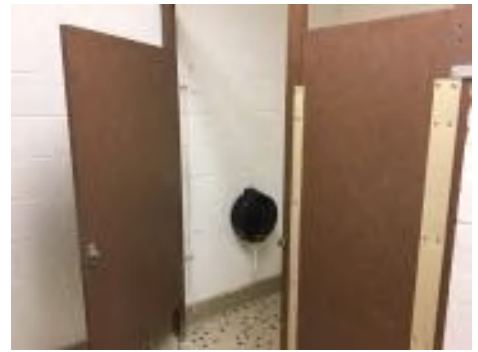
System: C1030 - Fittings

Note: The fittings are beyond their service life and should be replaced.

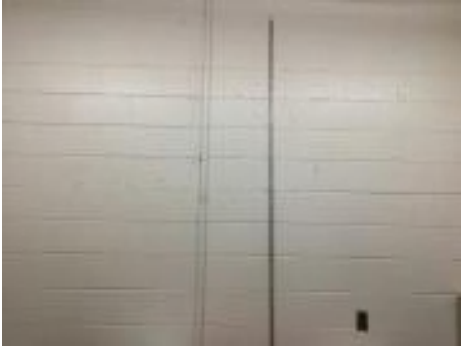
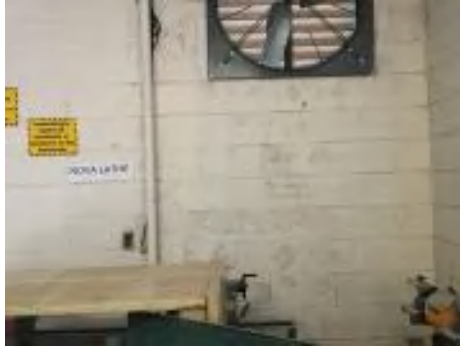
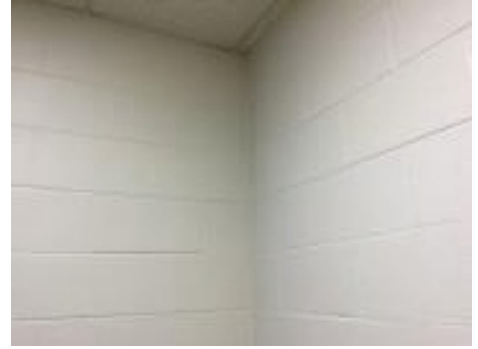
System: C3010 - Wall Finishes

Note: The wall finishes are beyond their service life and should be replaced.

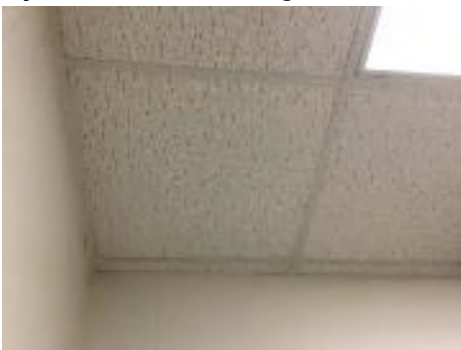
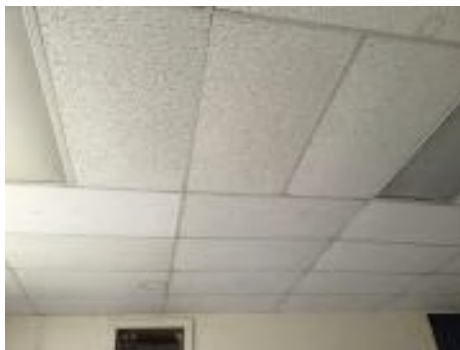
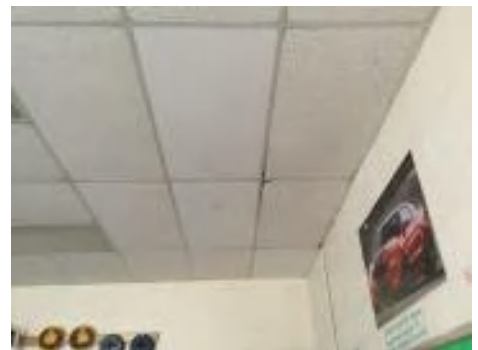
System: C3030 - Ceiling Finishes

Note: The ceiling finishes are beyond their service life and should be replaced.

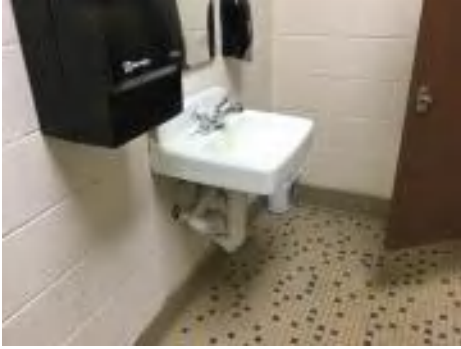
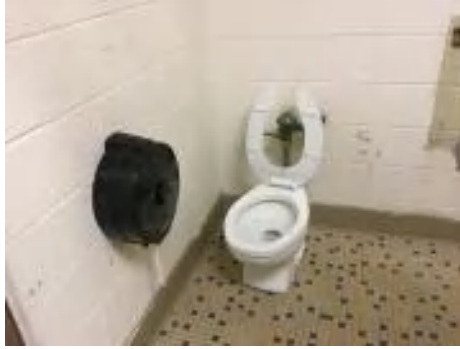
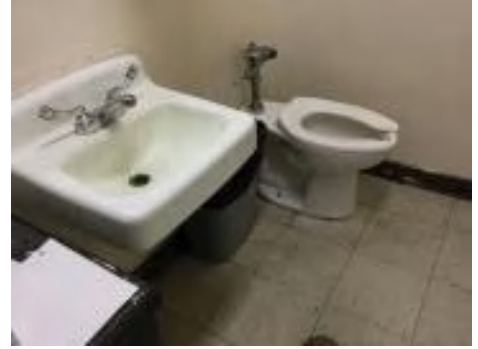
System: D2010 - Plumbing Fixtures

Note: The plumbing fixtures are beyond their service life and should be replaced.

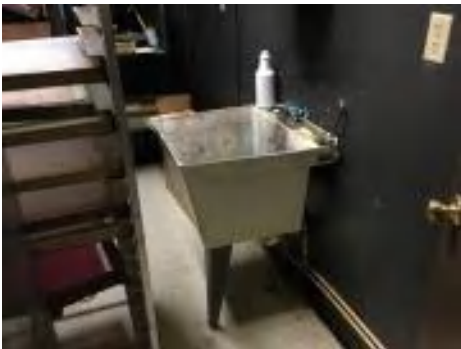
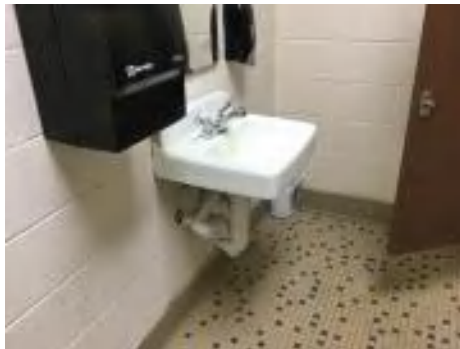
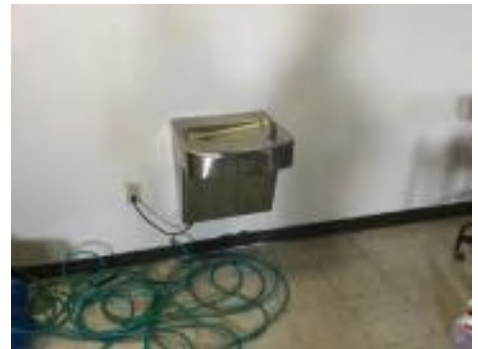
System: D2020 - Domestic Water Distribution

Note: The domestic water distribution system is beyond its service life and should be replaced.

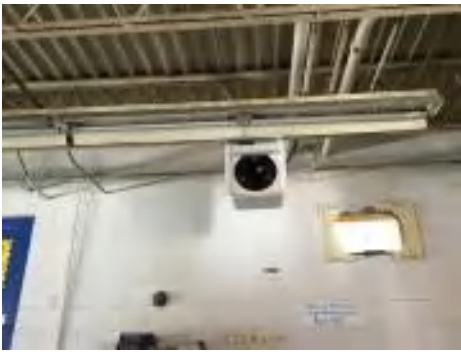
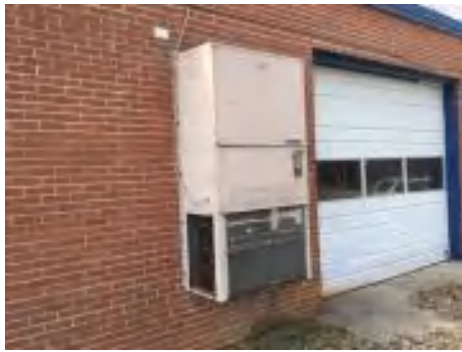
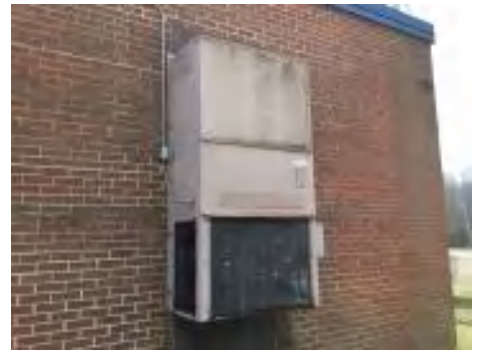
System: D3050 - Terminal & Package Units

Note: The terminal and package units are beyond their service life and should be replaced.

Notes: The terminal and package units are beyond their service life and should be replaced.

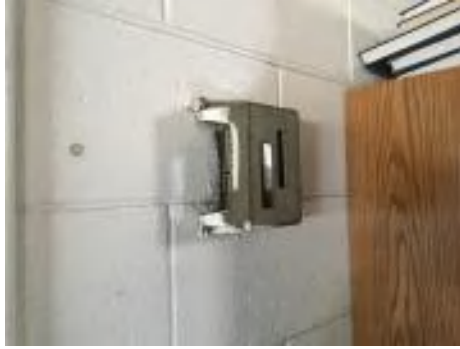
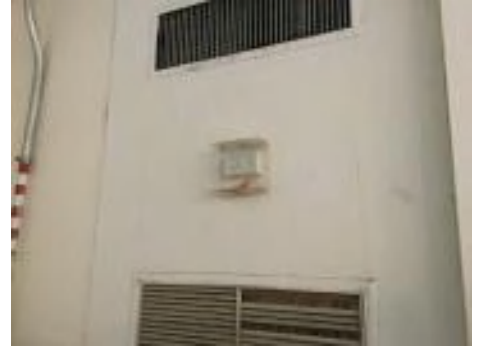
System: D3060 - Controls & Instrumentation

Note: The controls and instrumentation are beyond their service life and should be replaced.

Notes: The controls and instrumentation are beyond their service life and should be replaced.

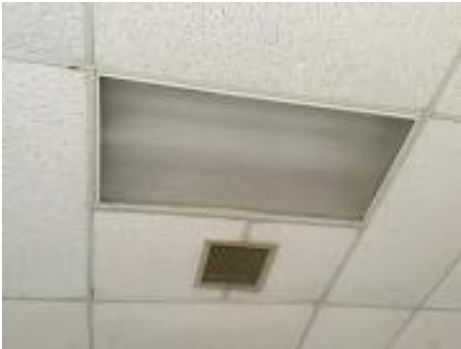
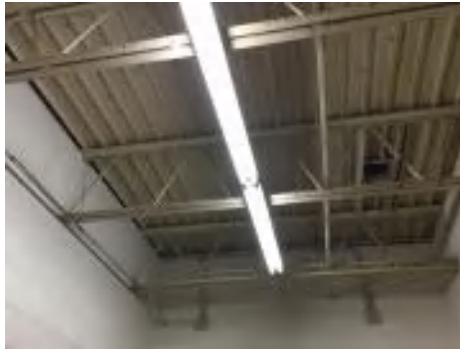
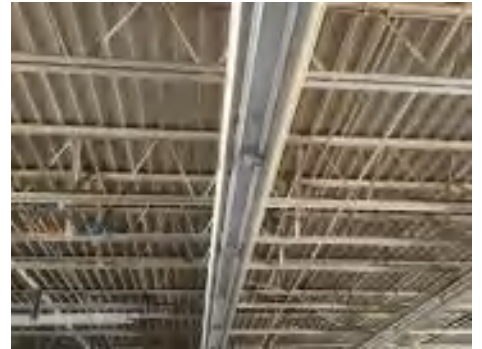
System: D5020 - Lighting

Note: The lighting system is beyond its service life and should be replaced.

Notes: The lighting system is beyond its service life and should be replaced.

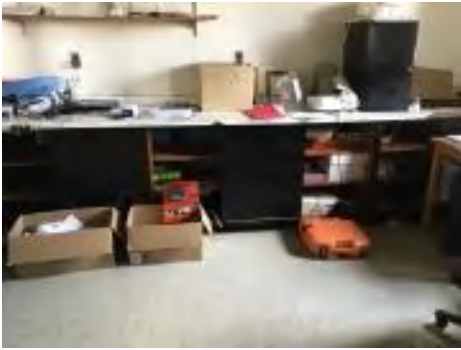
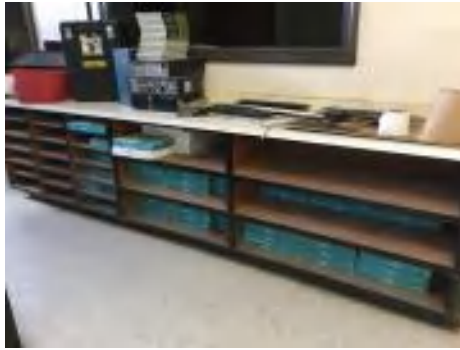
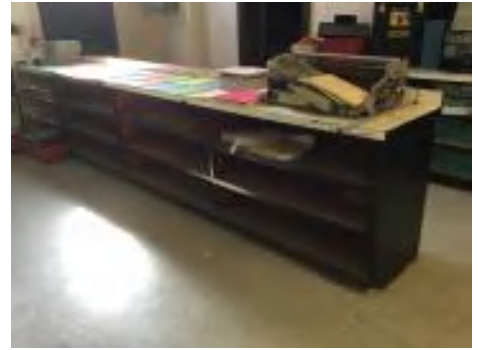
System: E2010 - Fixed Furnishings

Note: The fixed furnishings are beyond their service life and should be replaced.

Notes: The fixed furnishings are beyond their service life and should be replaced.

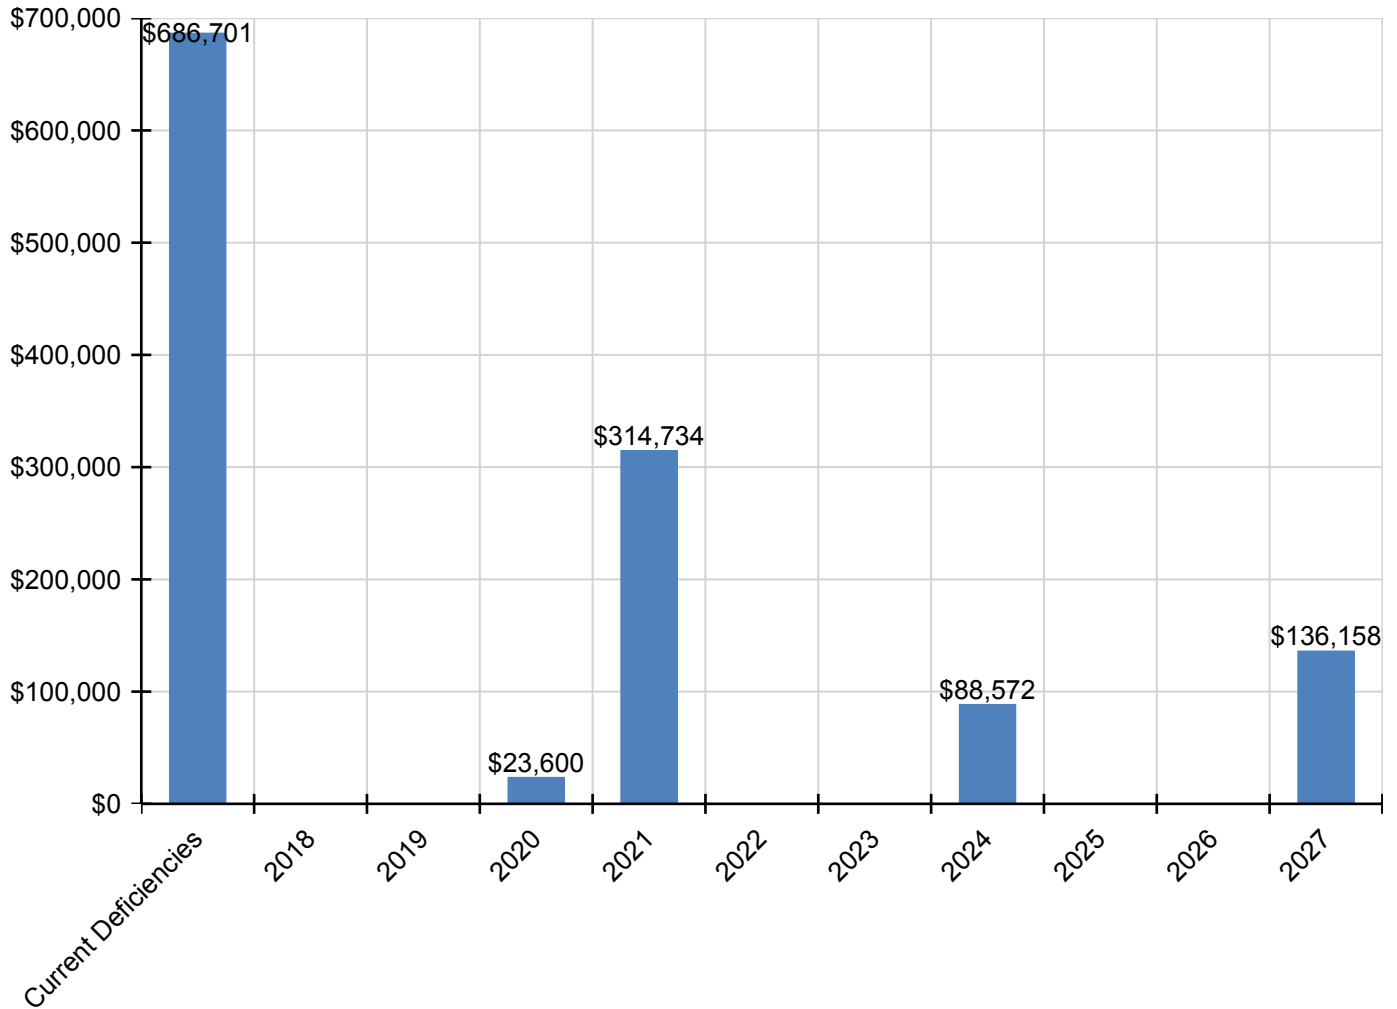
Forecasted Capital Renewal Requirement

The following chart shows the current building deficiencies and forecasting capital renewal or sustainment requirements over the next ten years.

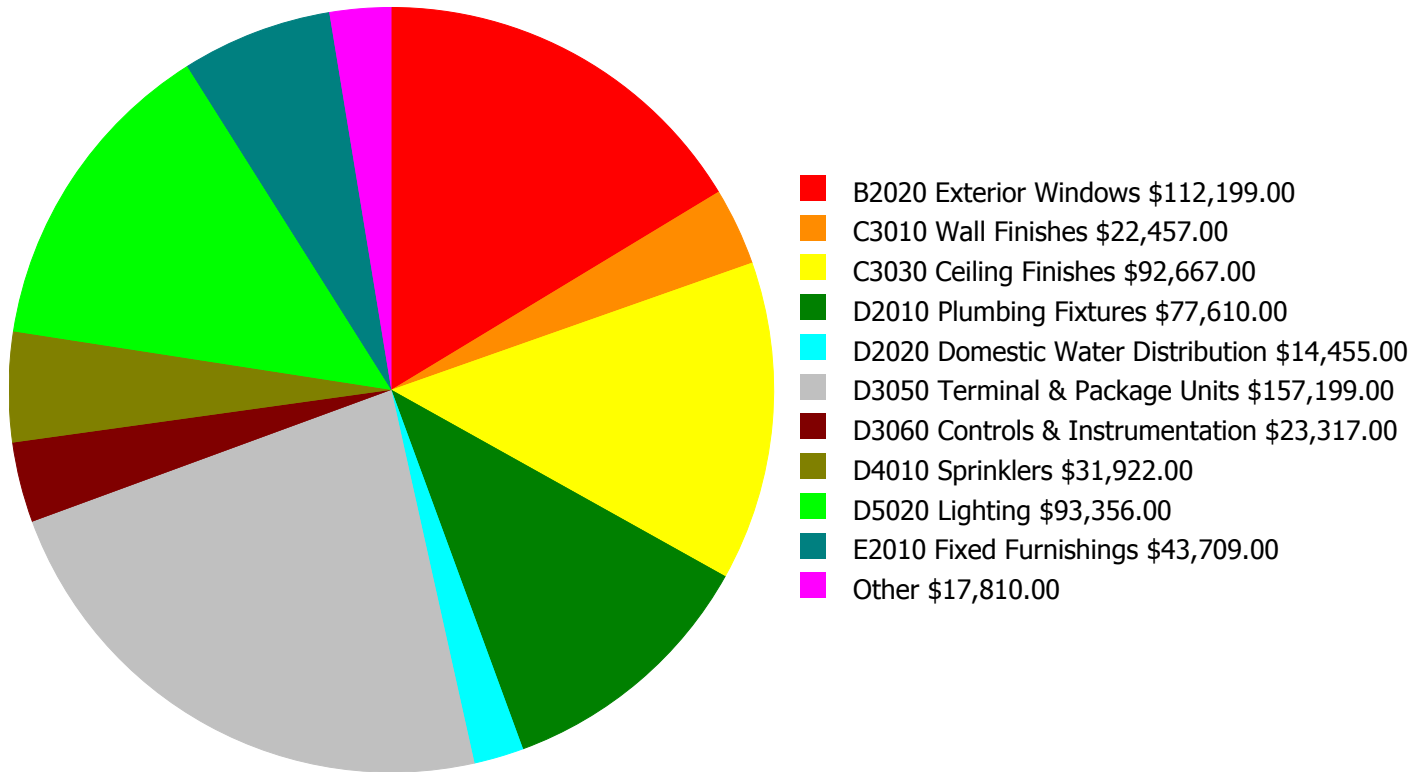
Deficiency Summary by System

Current deficiencies included assemblies that have reached or exceeded their design life or components of the assemblies that are in need of repair. Assemblies that have reached their design life are identified as current deficiencies and assigned the distress 'Beyond Useful Life'. The following chart lists all current deficiencies associated with this facility.

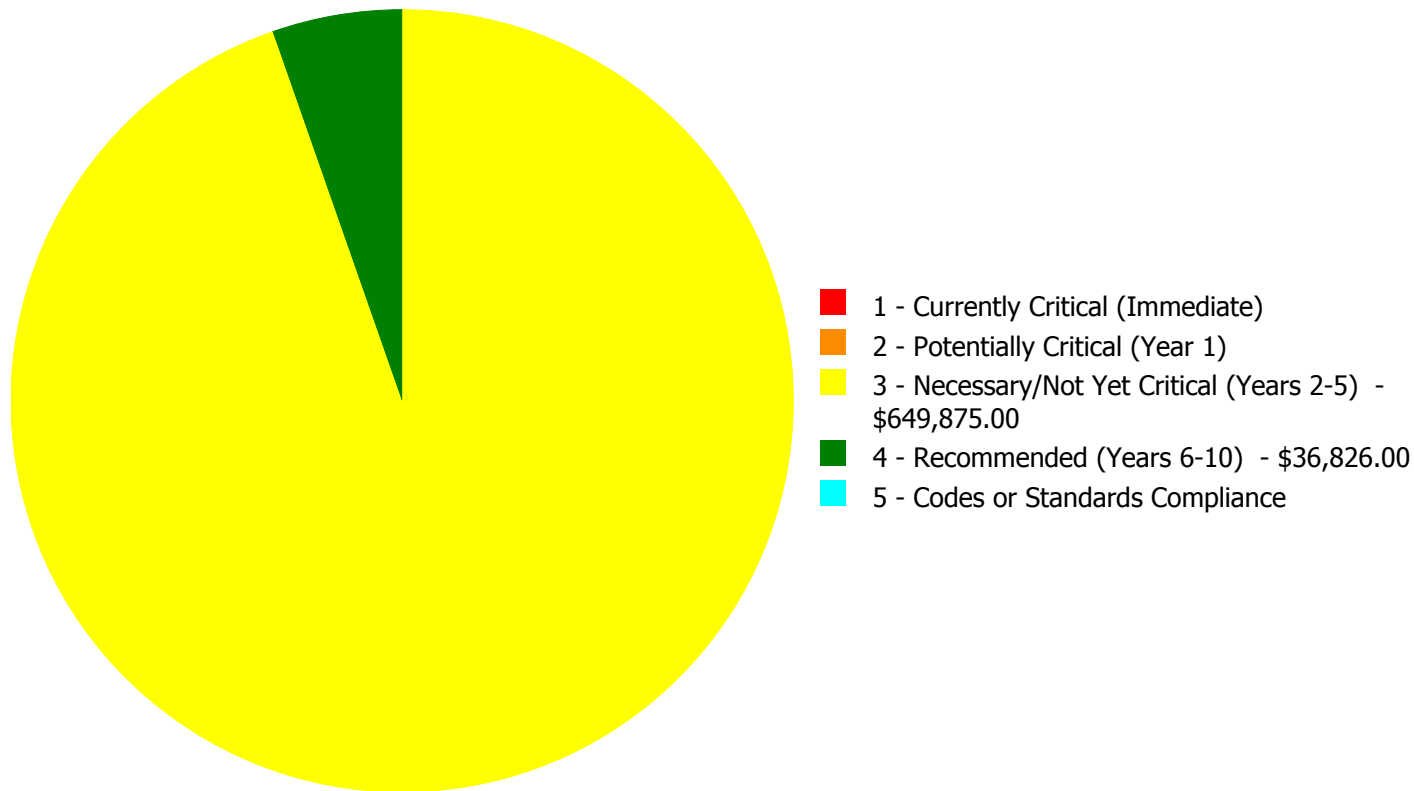
Deficiency Summary by Priority

The following chart shows the total repair costs broken down by priority. Assessors assigned deficiencies within eCOMET to one of the following priority categories:

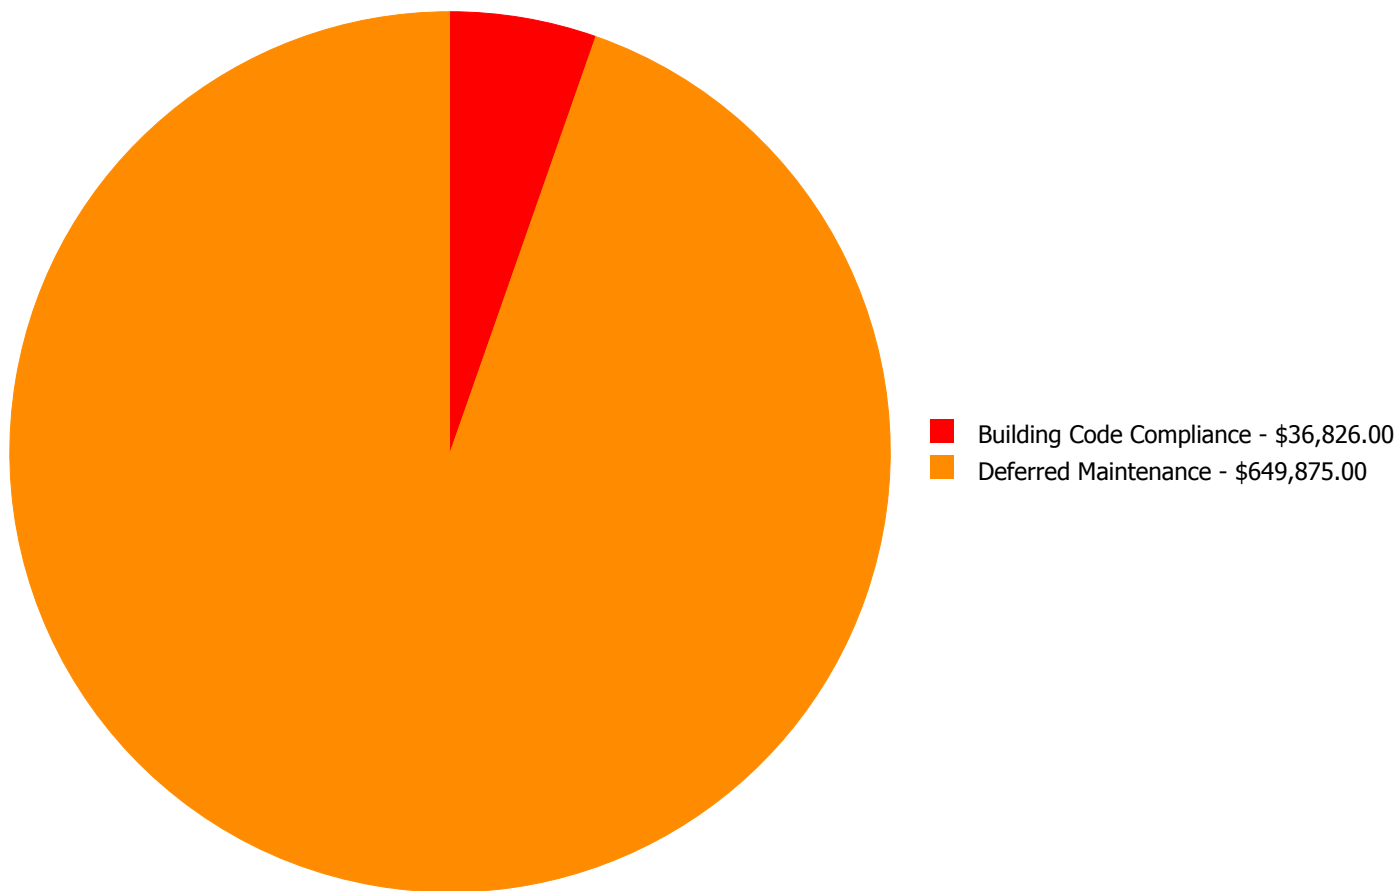
Deficiency Summary by Category

The following chart shows the total repair costs broken down by deficiency categories. Assessors assigned deficiencies to one of the following categories:

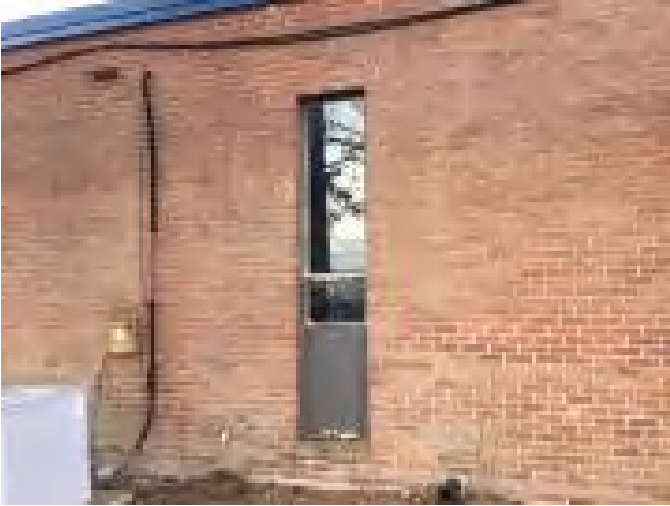
System: B2020 - Exterior Windows

Location: Exterior Walls
Distress: Beyond Service Life
Category: Deferred Maintenance
Priority: 3 - Necessary/Not Yet Critical (Years 2-5)
Correction: Renew System
Qty: 7,822.00
Unit of Measure: S.F.
Estimate: \$112,199.00
Assessor Name: Somnath Das
Date Created: 02/07/2017

Notes: The exterior windows are beyond their service life and should be replaced.

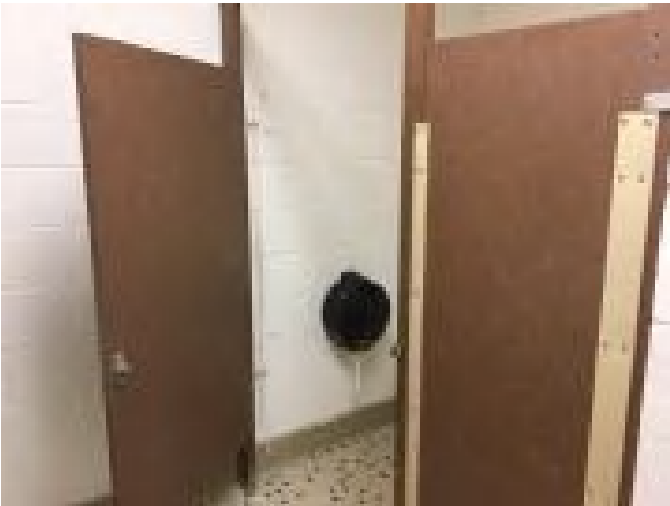
System: C1030 - Fittings

Location: Throughout Building
Distress: Beyond Service Life
Category: Deferred Maintenance
Priority: 3 - Necessary/Not Yet Critical (Years 2-5)
Correction: Renew System
Qty: 7,822.00
Unit of Measure: S.F.
Estimate: \$12,906.00
Assessor Name: Somnath Das
Date Created: 02/07/2017

Notes: The fittings are beyond their service life and should be replaced.

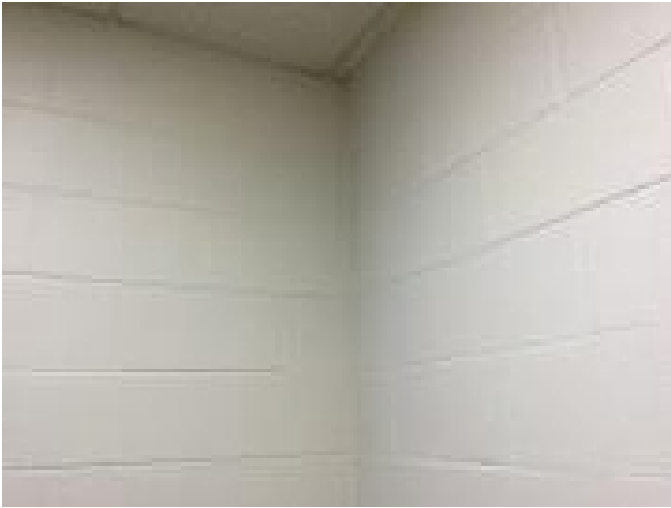
System: C3010 - Wall Finishes

Location: Throughout Building
Distress: Beyond Service Life
Category: Deferred Maintenance
Priority: 3 - Necessary/Not Yet Critical (Years 2-5)
Correction: Renew System
Qty: 7,822.00
Unit of Measure: S.F.
Estimate: \$22,457.00
Assessor Name: Somnath Das
Date Created: 02/07/2017

Notes: The wall finishes are beyond their service life and should be replaced.

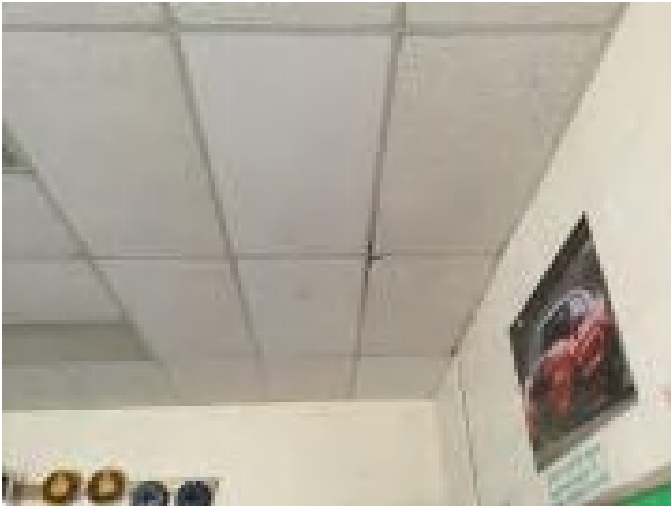
System: C3030 - Ceiling Finishes

Location: Throughout Building
Distress: Beyond Service Life
Category: Deferred Maintenance
Priority: 3 - Necessary/Not Yet Critical (Years 2-5)
Correction: Renew System
Qty: 7,822.00
Unit of Measure: S.F.
Estimate: \$92,667.00
Assessor Name: Somnath Das
Date Created: 02/07/2017

Notes: The ceiling finishes are beyond their service life and should be replaced.

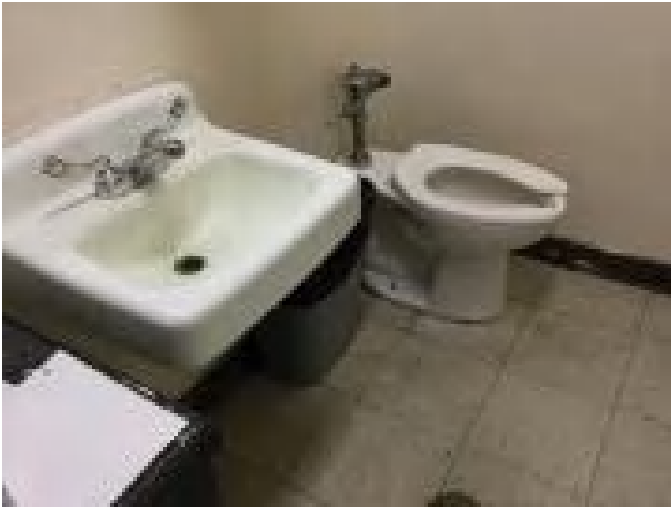
System: D2010 - Plumbing Fixtures

Location: Throughout Building
Distress: Beyond Service Life
Category: Deferred Maintenance
Priority: 3 - Necessary/Not Yet Critical (Years 2-5)
Correction: Renew System
Qty: 7,822.00
Unit of Measure: S.F.
Estimate: \$77,610.00
Assessor Name: Somnath Das
Date Created: 02/07/2017

Notes: The plumbing fixtures are beyond their service life and should be replaced.

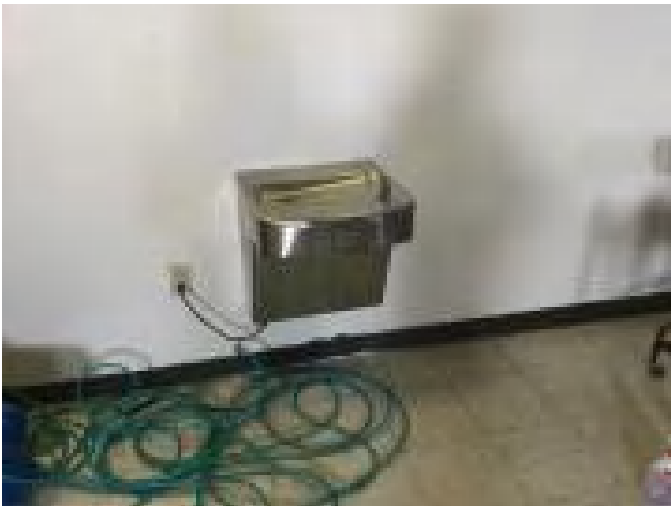
System: D2020 - Domestic Water Distribution

Location: Throughout Building
Distress: Beyond Service Life
Category: Deferred Maintenance
Priority: 3 - Necessary/Not Yet Critical (Years 2-5)
Correction: Renew System
Qty: 7,822.00
Unit of Measure: S.F.
Estimate: \$14,455.00
Assessor Name: Somnath Das
Date Created: 02/07/2017

Notes: The domestic water distribution system is beyond its service life and should be replaced.

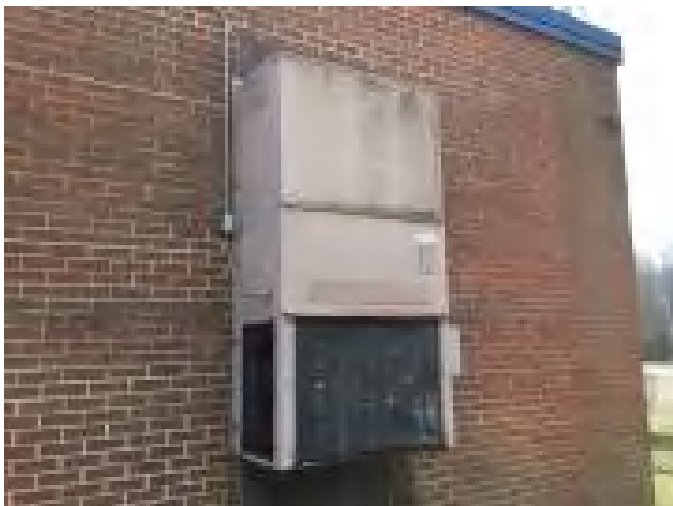
System: D3050 - Terminal & Package Units

Location: Throughout Building
Distress: Beyond Service Life
Category: Deferred Maintenance
Priority: 3 - Necessary/Not Yet Critical (Years 2-5)
Correction: Renew System
Qty: 7,822.00
Unit of Measure: S.F.
Estimate: \$157,199.00
Assessor Name: Somnath Das
Date Created: 02/07/2017

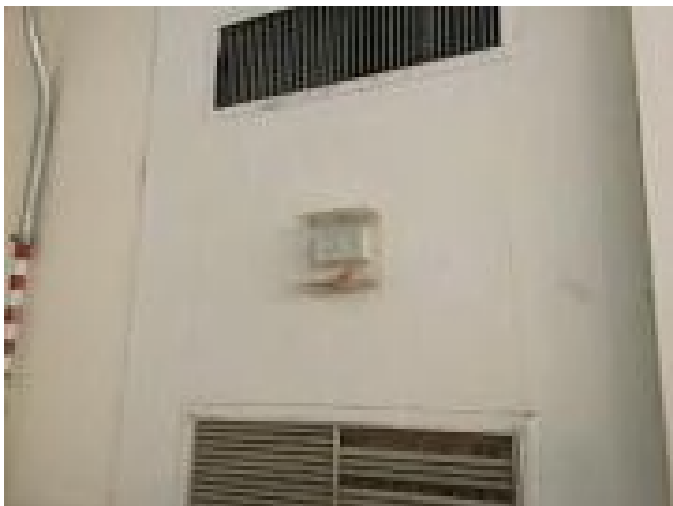
System: D3060 - Controls & Instrumentation

Location: Throughout Building
Distress: Beyond Service Life
Category: Deferred Maintenance
Priority: 3 - Necessary/Not Yet Critical (Years 2-5)
Correction: Renew System
Qty: 7,822.00
Unit of Measure: S.F.
Estimate: \$23,317.00
Assessor Name: Somnath Das
Date Created: 02/07/2017

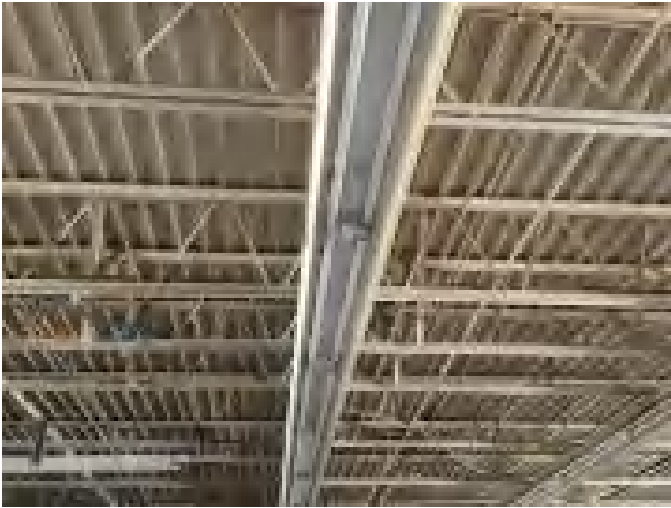
System: D5020 - Lighting

Location: Throughout Building
Distress: Beyond Service Life
Category: Deferred Maintenance
Priority: 3 - Necessary/Not Yet Critical (Years 2-5)
Correction: Renew System
Qty: 7,822.00
Unit of Measure: S.F.
Estimate: \$93,356.00
Assessor Name: Somnath Das
Date Created: 02/07/2017

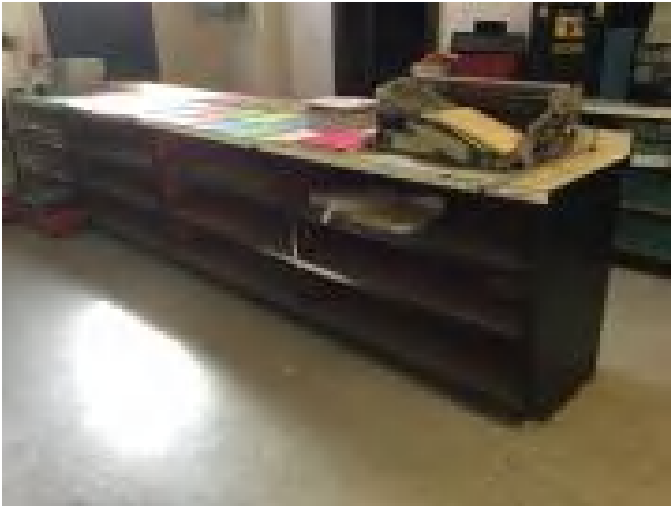
System: E2010 - Fixed Furnishings

Location: Throughout Building
Distress: Beyond Service Life
Category: Deferred Maintenance
Priority: 3 - Necessary/Not Yet Critical (Years 2-5)
Correction: Renew System
Qty: 7,822.00
Unit of Measure: S.F.
Estimate: \$43,709.00
Assessor Name: Somnath Das
Date Created: 02/07/2017

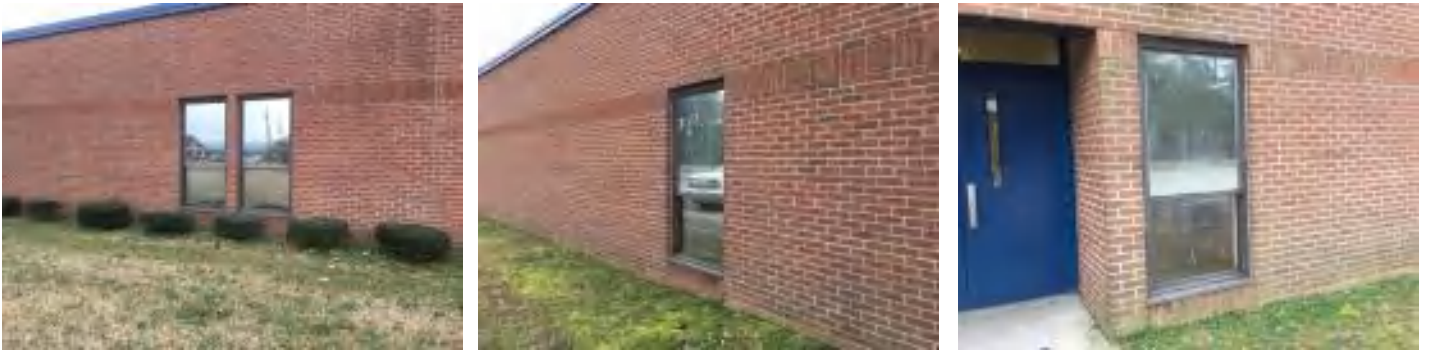
System: B2020 - Exterior Windows

Note: The exterior windows are beyond their service life and should be replaced.

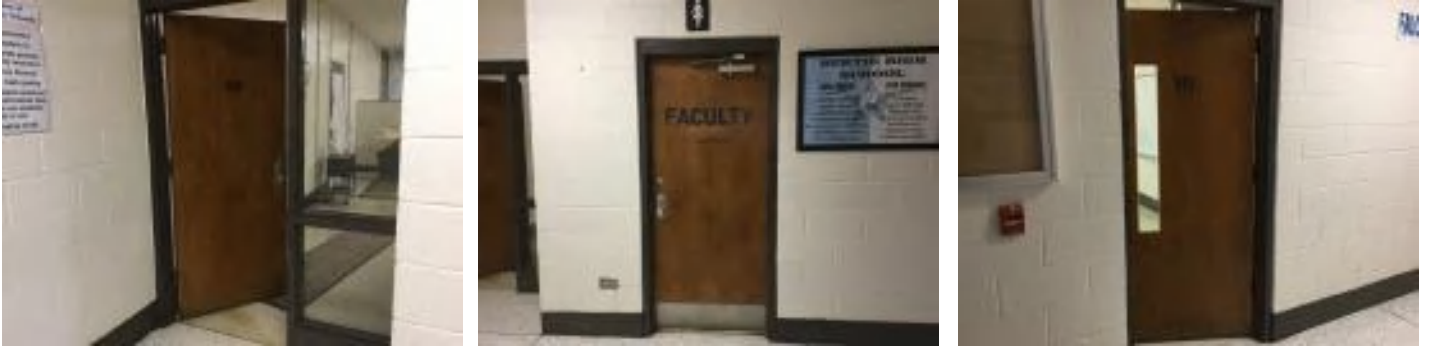
System: C1020 - Interior Doors

Note: The interior doors are beyond their service life and should be replaced.

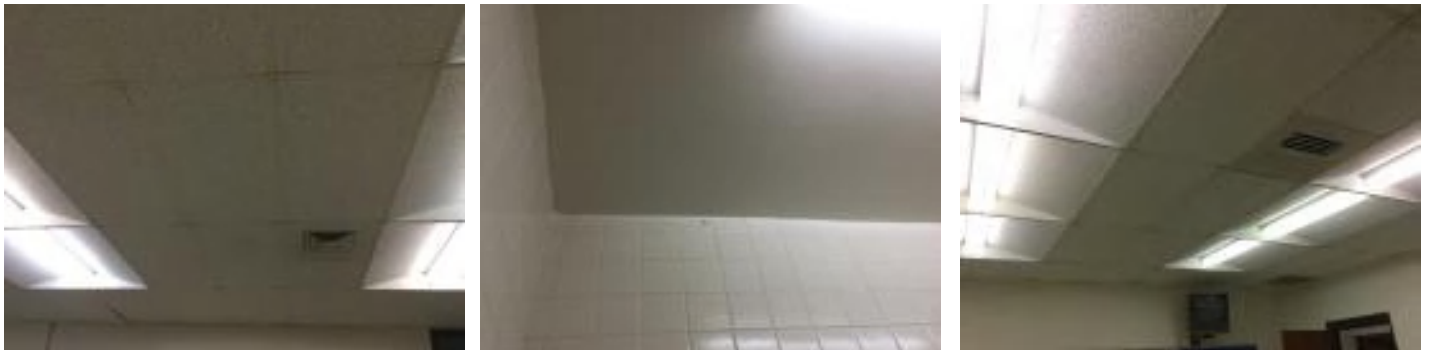
System: C3030 - Ceiling Finishes

Note: The acoustical ceiling tiles are beyond their service life and should be replaced.

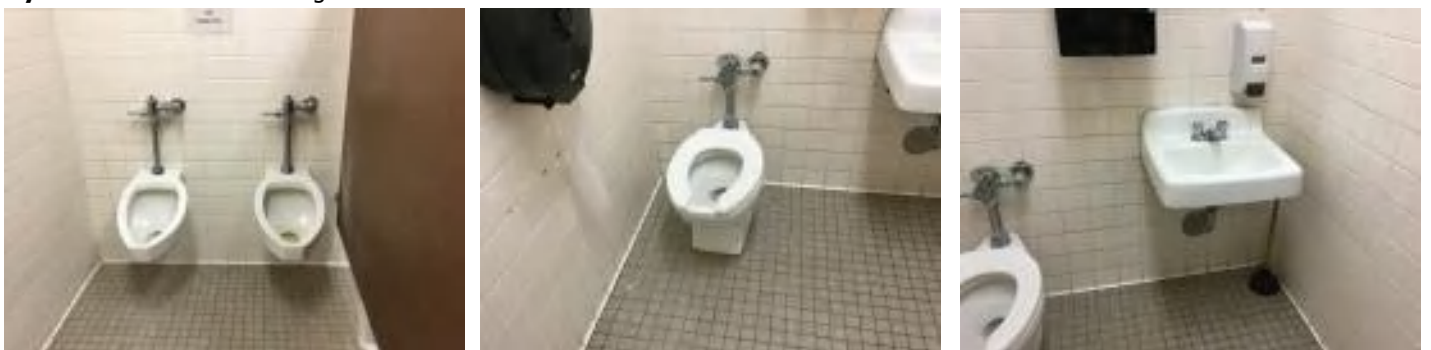
System: D2010 - Plumbing Fixtures

Note: The plumbing fixtures are beyond their service life and should be replaced.

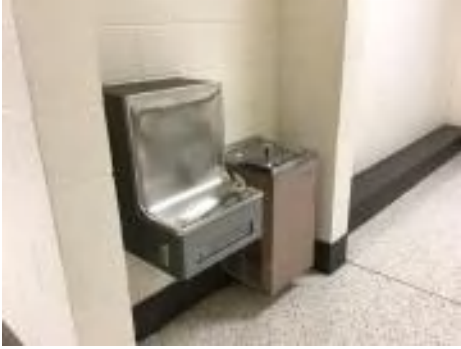
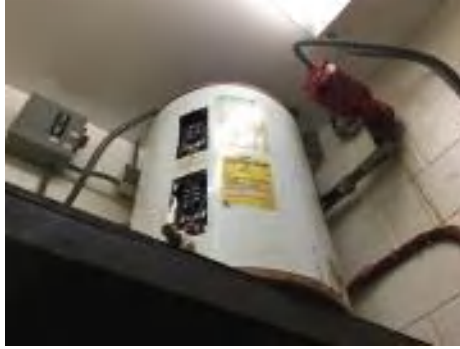
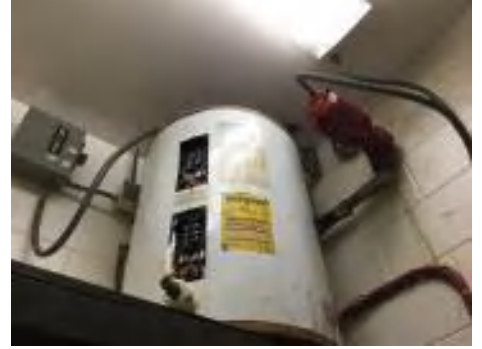
System: D2020 - Domestic Water Distribution

Note: The domestic water distribution system is beyond its service life and should be replaced.

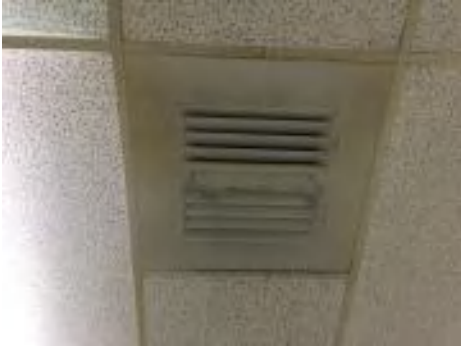
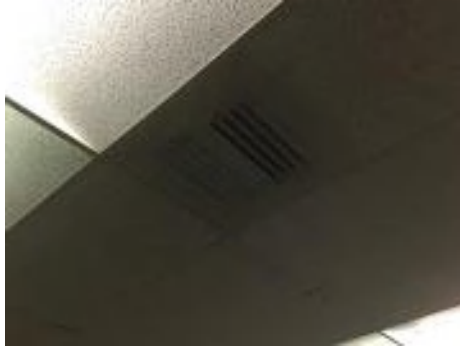
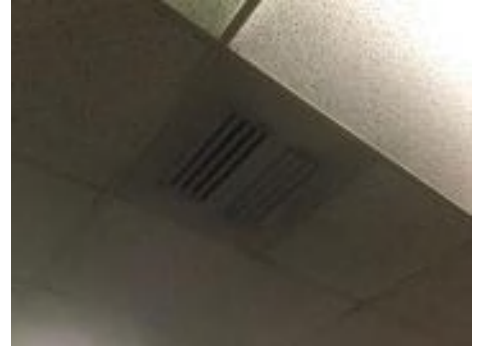
System: D3040 - Distribution Systems

Note: The distribution system is beyond its service life and should be replaced.

Notes: The distribution system is beyond its service life and should be replaced.

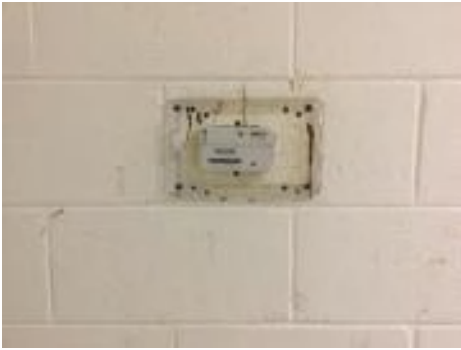
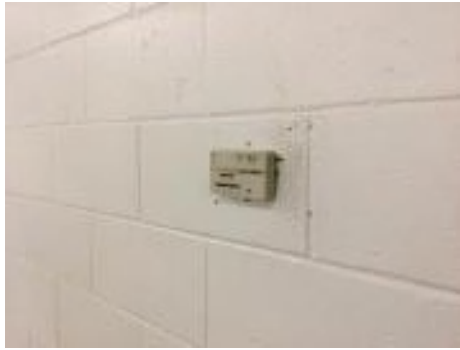
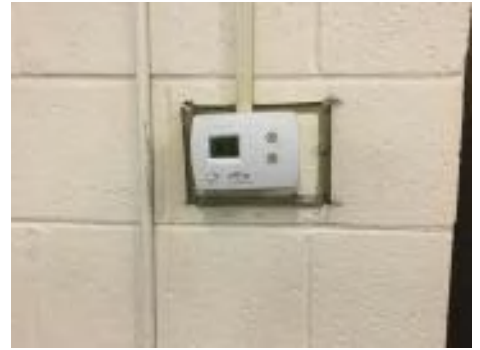
System: D3060 - Controls & Instrumentation

Note: The controls and instrumentation system is beyond its service life and should be replaced.

Notes: The controls and instrumentation system is beyond its service life and should be replaced.

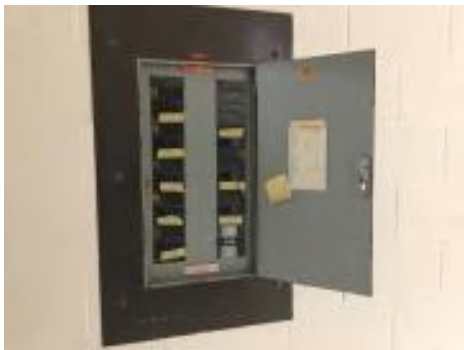
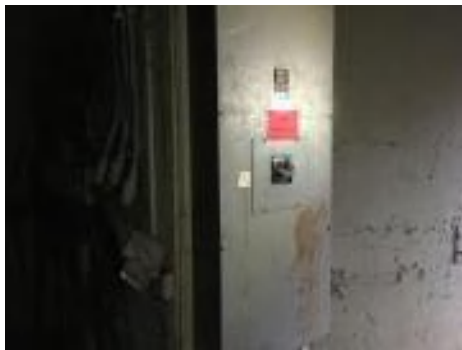
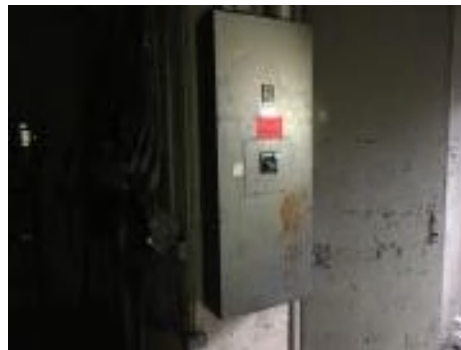
System: D5010 - Electrical Service/Distribution

Note: The electrical distribution system is beyond its service life and should be replaced.
