NC School District/080 Bertie County/Middle School

Bertie Middle

Campus Assessment Report

March 8, 2017

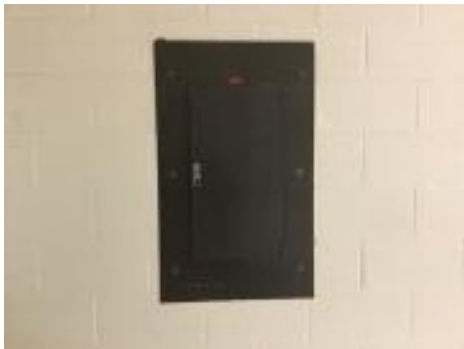
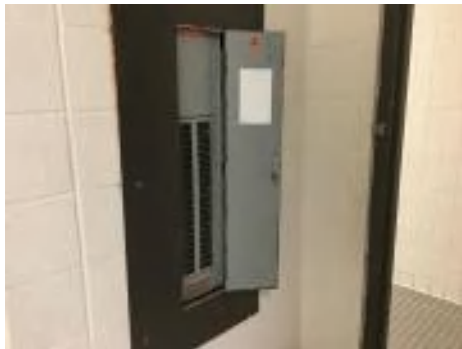
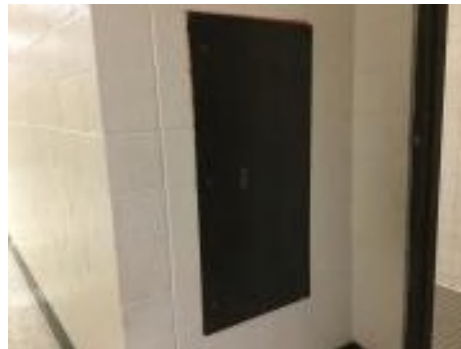
System: D5020 - Branch Wiring

Note: The branch wiring system is beyond its service life and should be replaced.

Notes: The branch wiring system is beyond its service life and should be replaced.

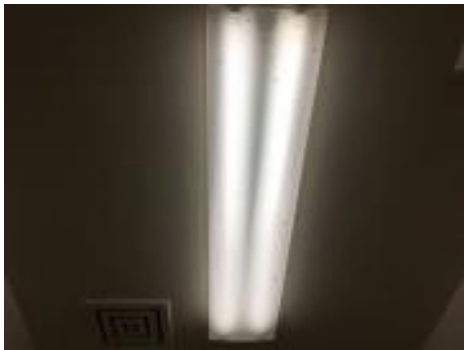
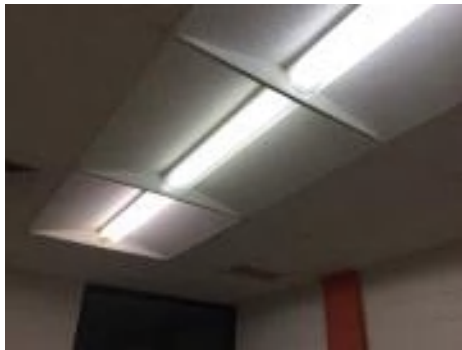
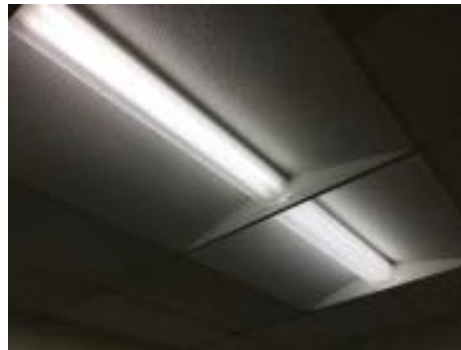
System: D5020 - Lighting

Note: The lighting system is beyond its service life and should be replaced.

Notes: The lighting system is beyond its service life and should be replaced.

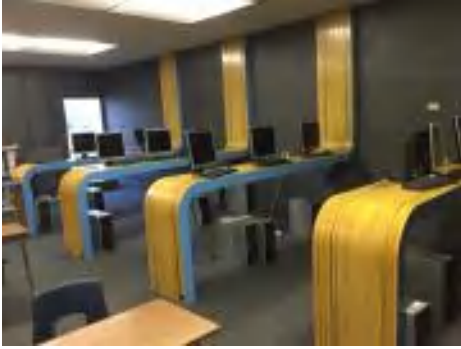
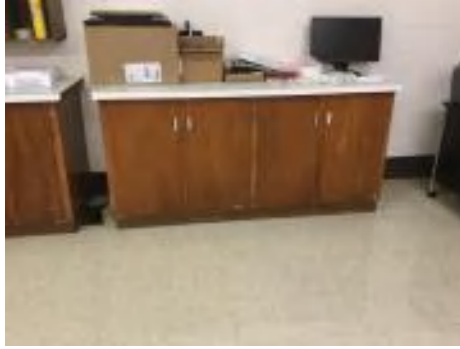
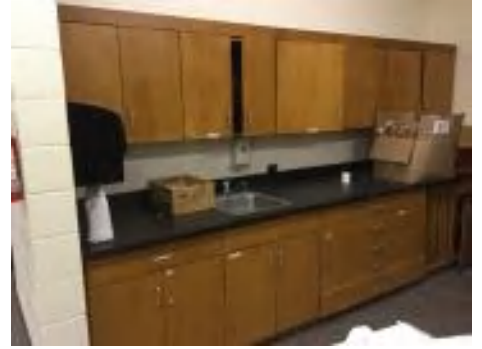
System: E2010 - Fixed Furnishings

Note: The fixed furnishings are beyond their service life and should be replaced.

Notes: The fixed furnishings are beyond their service life and should be replaced.

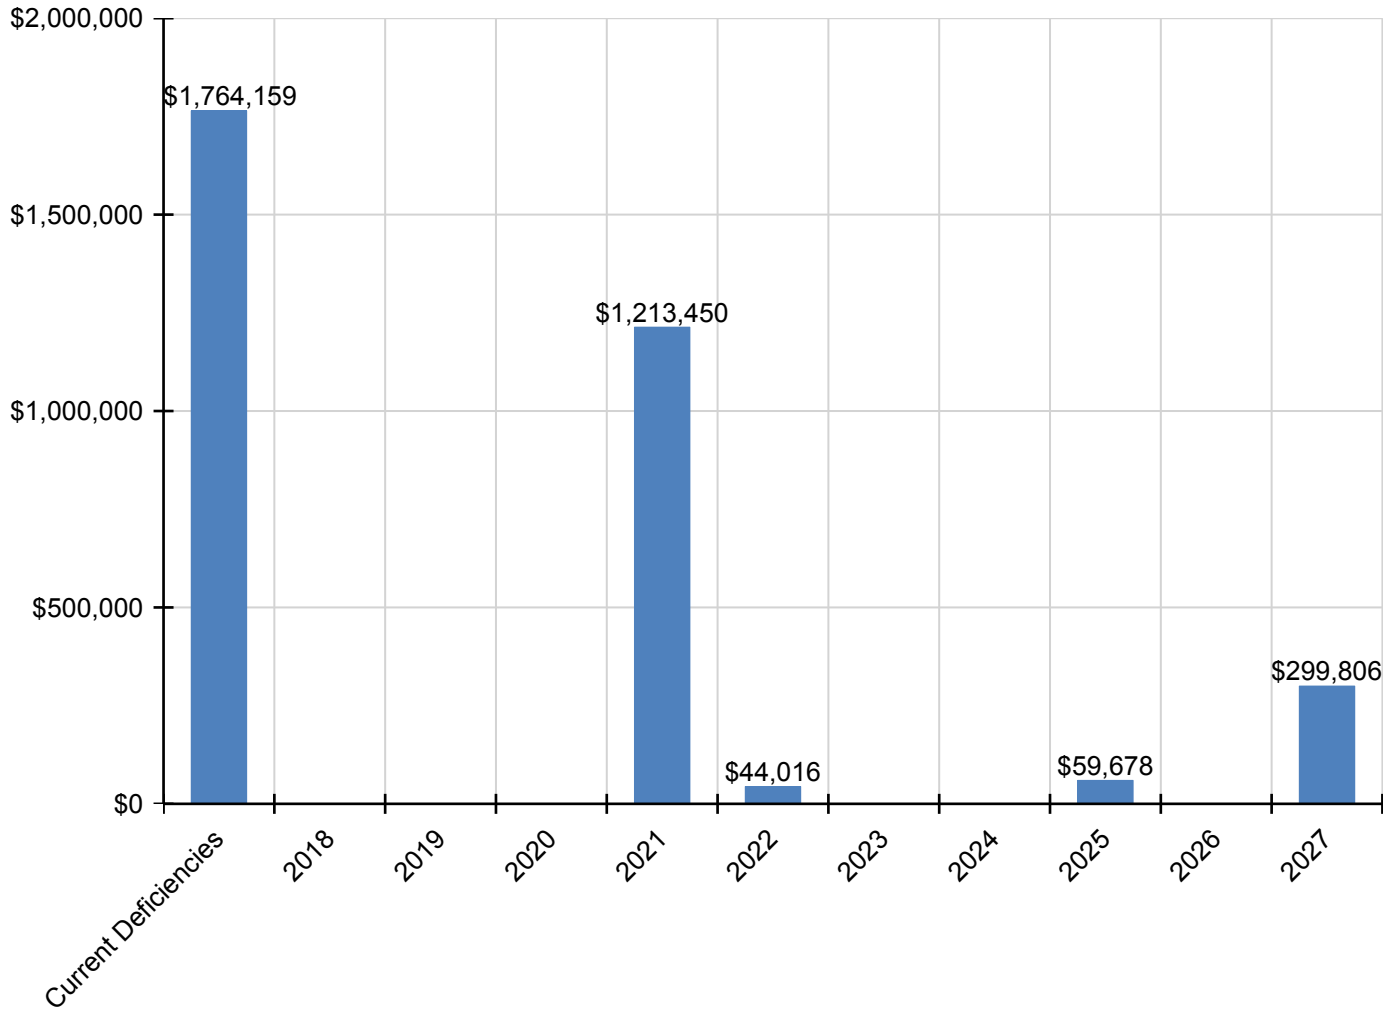
Forecasted Capital Renewal Requirement

The following chart shows the current building deficiencies and forecasting capital renewal or sustainment requirements over the next ten years.

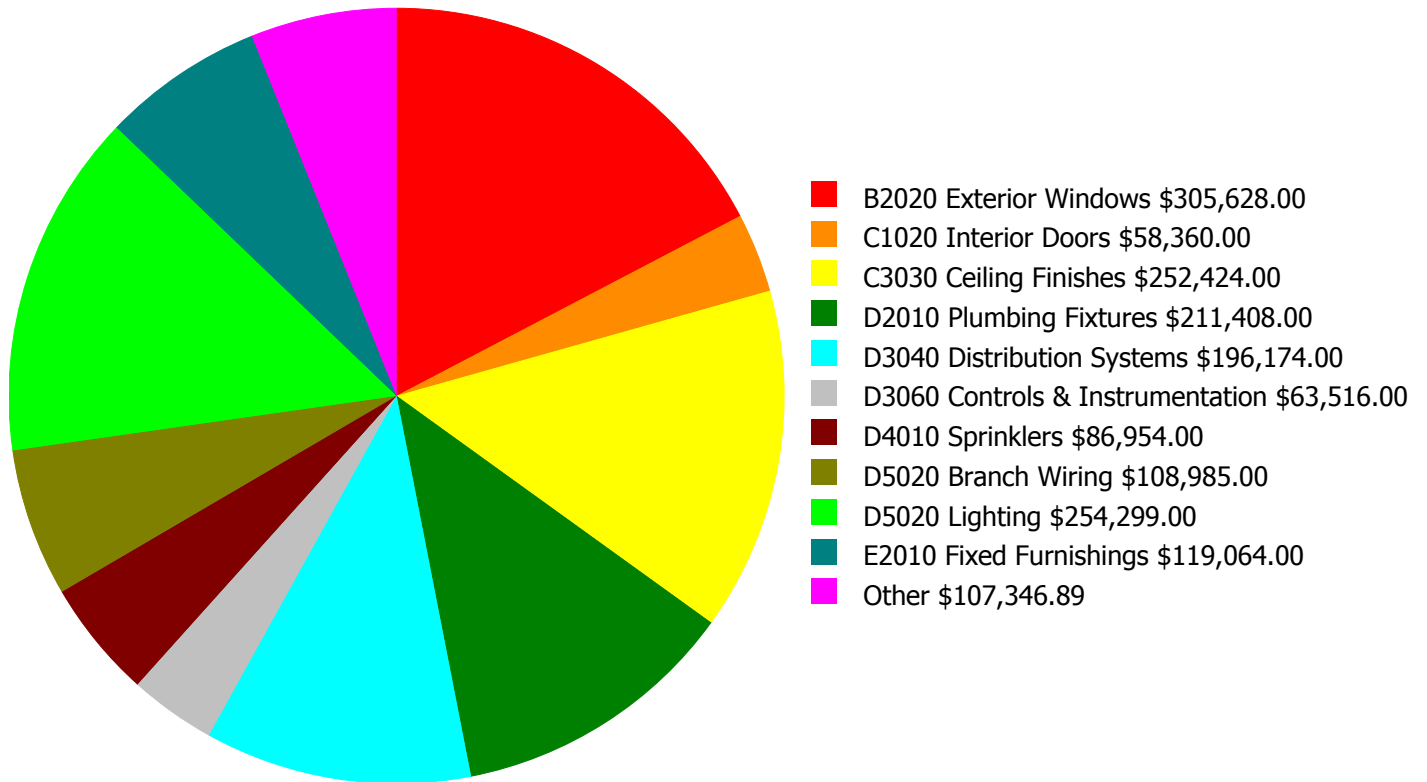
Deficiency Summary by System

Current deficiencies included assemblies that have reached or exceeded their design life or components of the assemblies that are in need of repair. Assemblies that have reached their design life are identified as current deficiencies and assigned the distress 'Beyond Useful Life'. The following chart lists all current deficiencies associated with this facility.

Budget Estimate Total: \$1,764,158.89

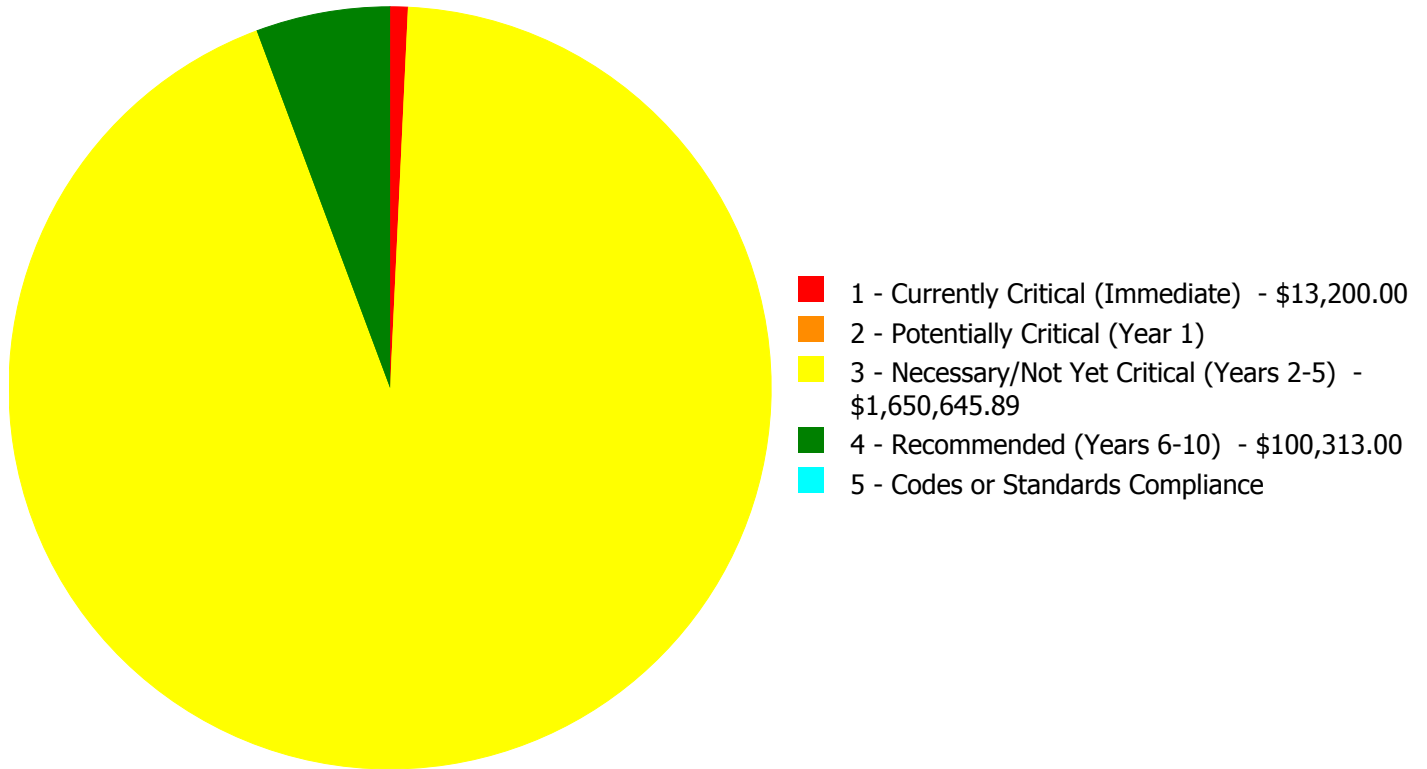
Deficiency Summary by Priority

The following chart shows the total repair costs broken down by priority. Assessors assigned deficiencies within eCOMET to one of the following priority categories:

Budget Estimate Total: \$1,764,158.89

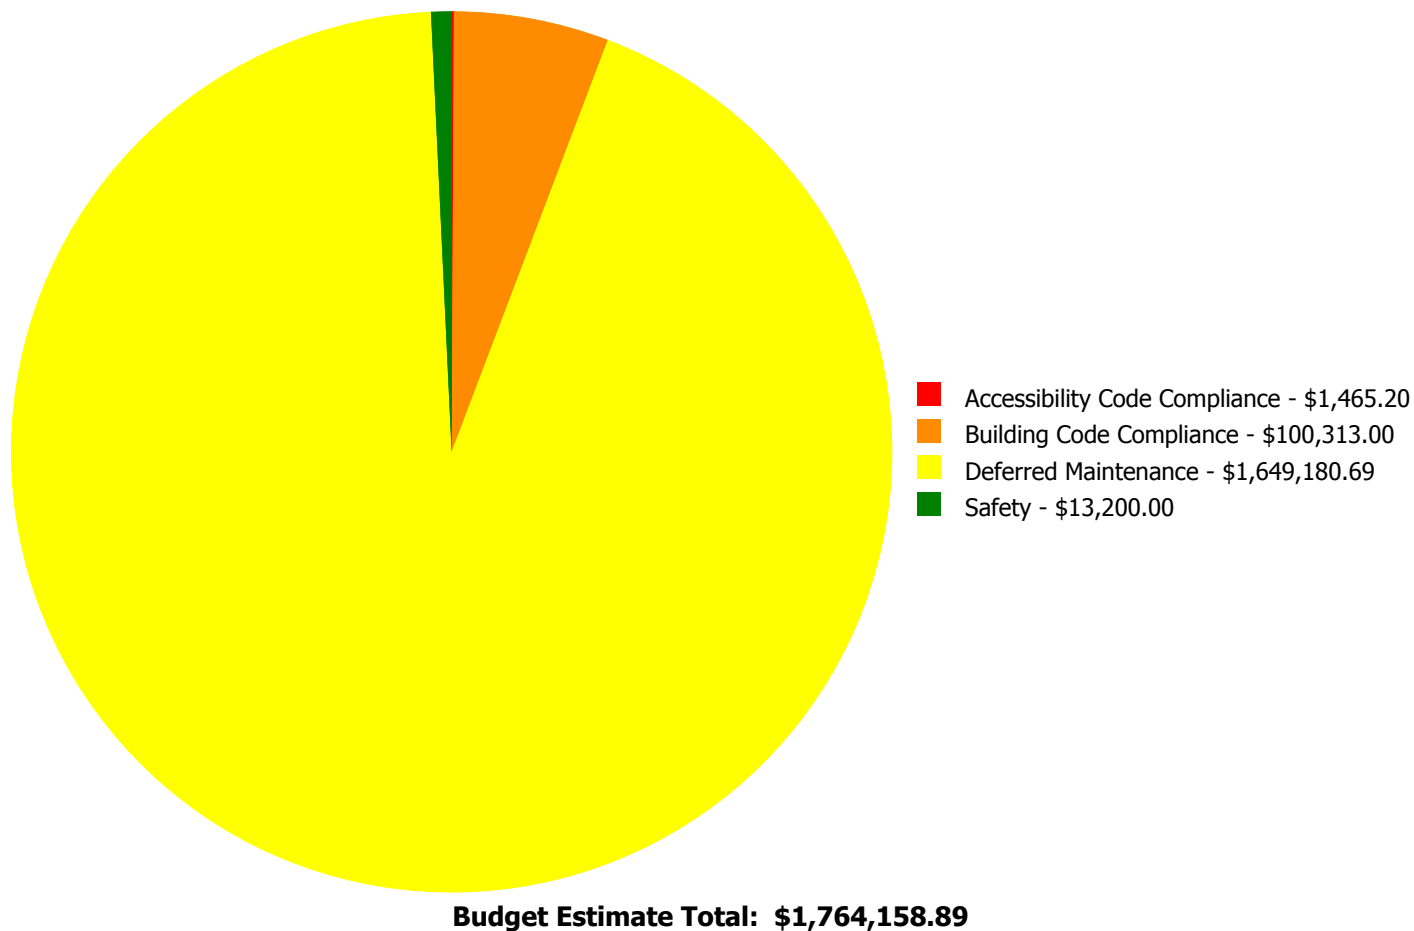
Deficiency Summary by Category

The following chart shows the total repair costs broken down by deficiency categories. Assessors assigned deficiencies to one of the following categories:

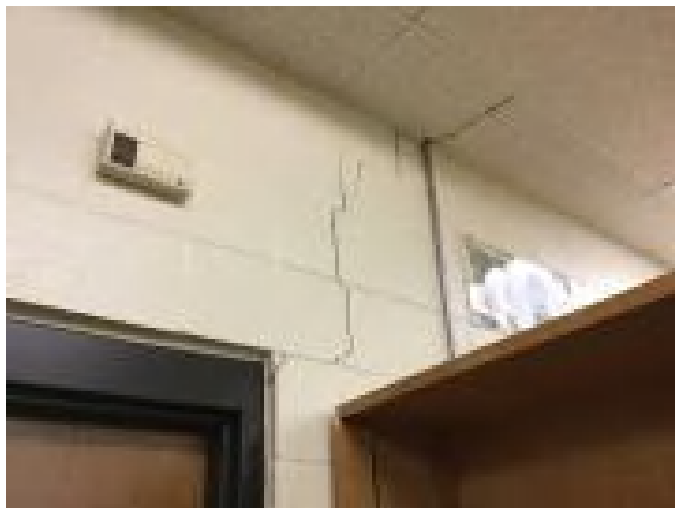
System: C1010 - Partitions

Location: Room 906
Distress: Failing
Category: Safety
Priority: 1 - Currently Critical (Immediate)
Correction: Engineering Study
Qty: 1.00
Unit of Measure: Ea.
Estimate: \$13,200.00
Assessor Name: Somnath Das
Date Created: 02/01/2017

Notes: There are visible cracks on the partition wall which should be studied by a professional engineer.

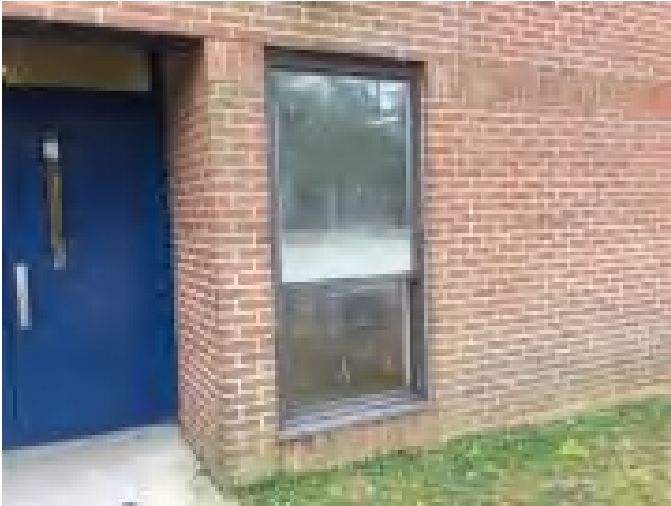
System: B2020 - Exterior Windows

Location: Exterior Walls
Distress: Beyond Service Life
Category: Deferred Maintenance
Priority: 3 - Necessary/Not Yet Critical (Years 2-5)
Correction: Renew System
Qty: 21,307.00
Unit of Measure: S.F.
Estimate: \$305,628.00
Assessor Name: Somnath Das
Date Created: 02/07/2017

Notes: The exterior windows are beyond their service life and should be replaced.

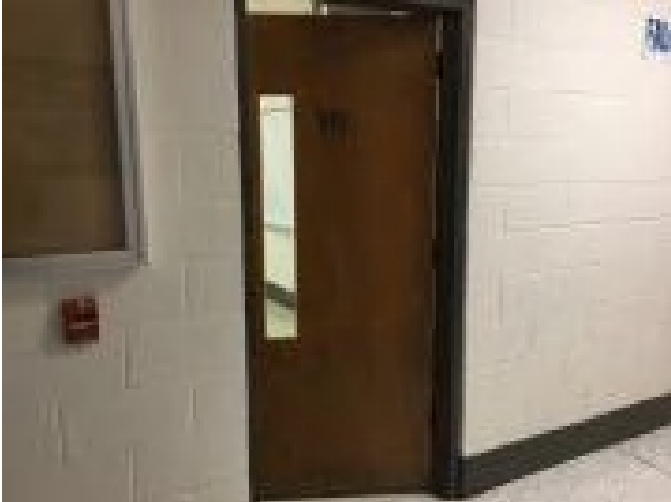
System: C1020 - Interior Doors

Location: Throughout Building
Distress: Beyond Service Life
Category: Deferred Maintenance
Priority: 3 - Necessary/Not Yet Critical (Years 2-5)
Correction: Renew System
Qty: 21,307.00
Unit of Measure: S.F.
Estimate: \$58,360.00
Assessor Name: Somnath Das
Date Created: 02/07/2017

Notes: The interior doors are beyond their service life and should be replaced.

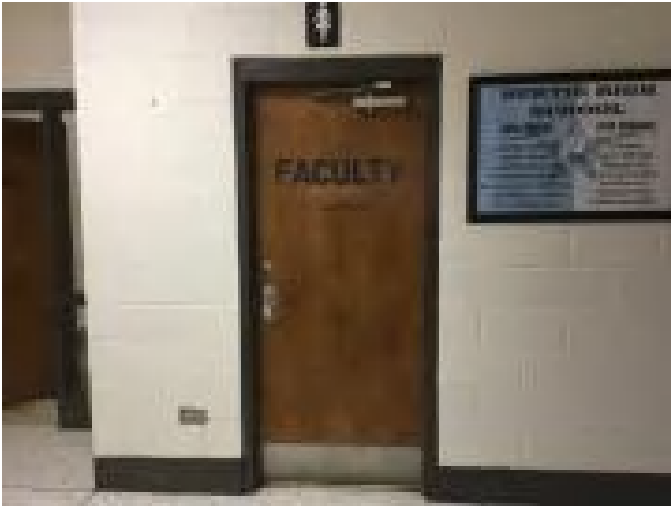
System: C1030 - Fittings

Location: Throughout the building
Distress: Inadequate
Category: Accessibility Code Compliance
Priority: 3 - Necessary/Not Yet Critical (Years 2-5)
Correction: Replace signage and toilet partitions
Qty: 30.00
Unit of Measure: Ea.
Estimate: \$1,465.20
Assessor Name: Somnath Das
Date Created: 02/01/2017

Notes: The signages throughout the building are not ADA compliant and should be replaced.

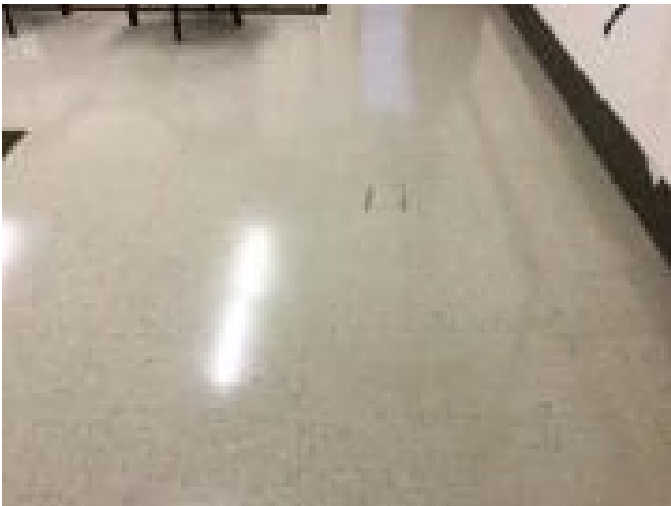
System: C3020 - Floor Finishes

Location: Throughout the building
Distress: Beyond Service Life
Category: Deferred Maintenance
Priority: 3 - Necessary/Not Yet Critical (Years 2-5)
Correction: Replace vinyl tile flooring
Qty: 300.00
Unit of Measure: S.Y.
Estimate: \$32,254.20
Assessor Name: Somnath Das
Date Created: 02/01/2017

Notes: The VCT tiles are beyond their service life and should be replaced.

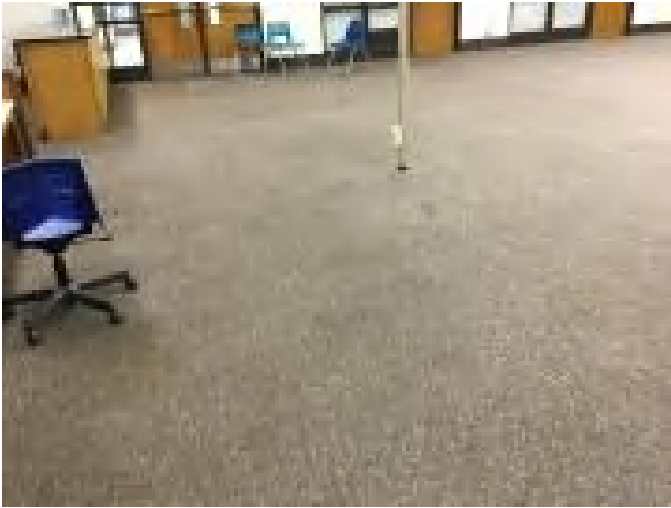
System: C3020 - Floor Finishes

Location: Media Center
Distress: Beyond Service Life
Category: Deferred Maintenance
Priority: 3 - Necessary/Not Yet Critical (Years 2-5)
Correction: Replace carpet
Qty: 90.00
Unit of Measure: S.Y.
Estimate: \$7,693.49
Assessor Name: Somnath Das
Date Created: 02/01/2017

Notes: The carpet is beyond its service life and should be replaced.

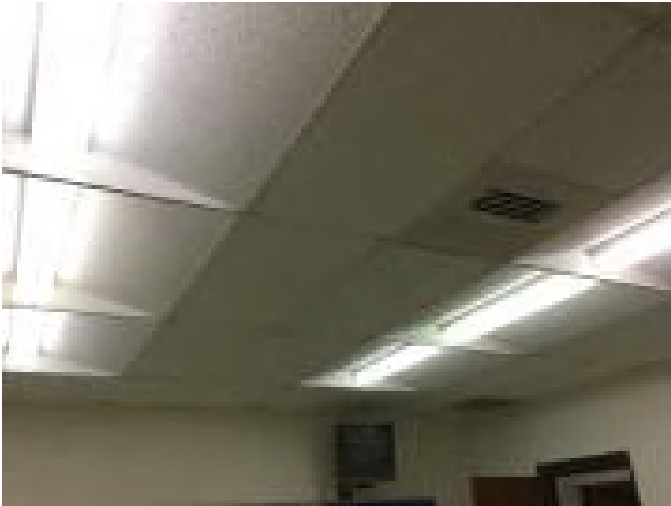
System: C3030 - Ceiling Finishes

Location: Throughout Building
Distress: Beyond Service Life
Category: Deferred Maintenance
Priority: 3 - Necessary/Not Yet Critical (Years 2-5)
Correction: Renew System
Qty: 21,307.00
Unit of Measure: S.F.
Estimate: \$252,424.00
Assessor Name: Somnath Das
Date Created: 02/07/2017

Notes: The acoustical ceiling tiles are beyond their service life and should be replaced.

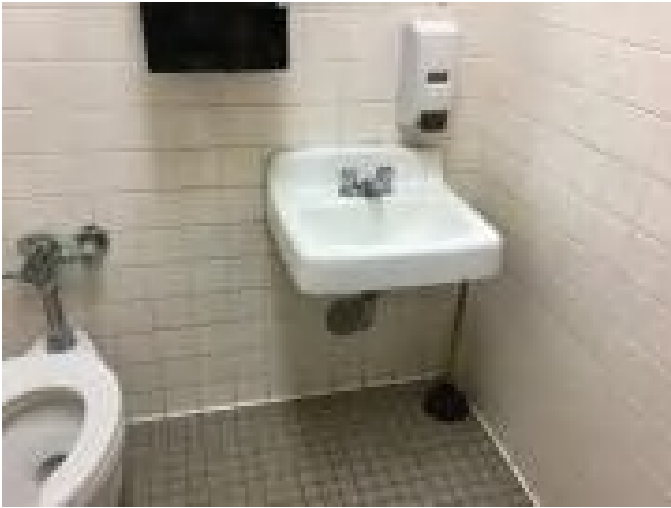
System: D2010 - Plumbing Fixtures

Location: Throughout Building
Distress: Beyond Service Life
Category: Deferred Maintenance
Priority: 3 - Necessary/Not Yet Critical (Years 2-5)
Correction: Renew System
Qty: 21,307.00
Unit of Measure: S.F.
Estimate: \$211,408.00
Assessor Name: Somnath Das
Date Created: 02/07/2017

Notes: The plumbing fixtures are beyond their service life and should be replaced.

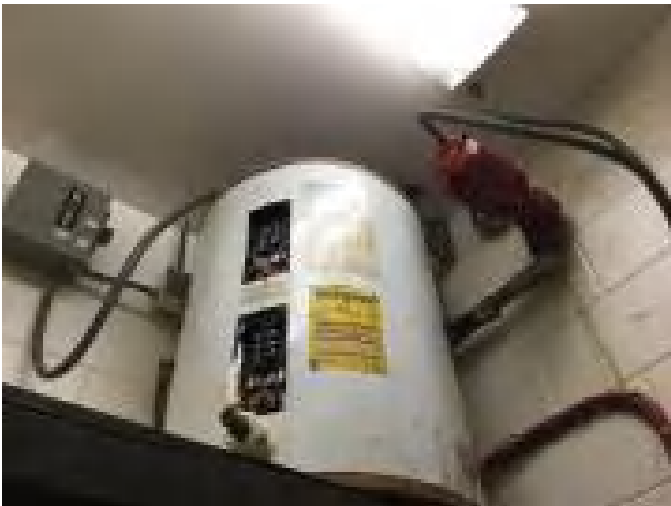
System: D2020 - Domestic Water Distribution

Location: Throughout Building
Distress: Beyond Service Life
Category: Deferred Maintenance
Priority: 3 - Necessary/Not Yet Critical (Years 2-5)
Correction: Renew System
Qty: 21,307.00
Unit of Measure: S.F.
Estimate: \$39,375.00
Assessor Name: Somnath Das
Date Created: 02/07/2017

Notes: The domestic water distribution system is beyond its service life and should be replaced.

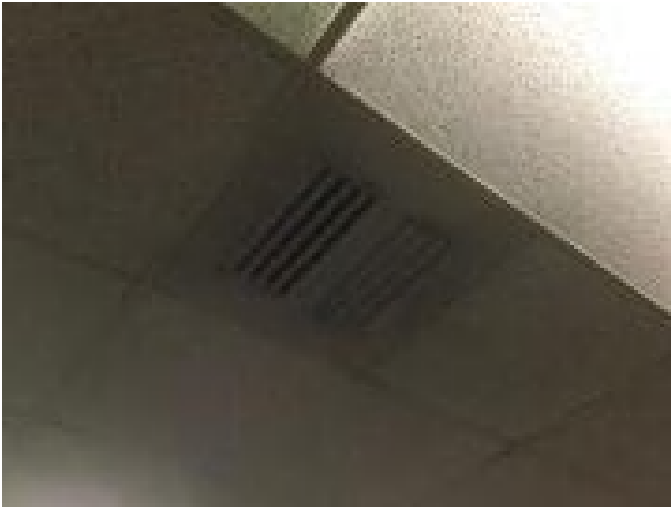
System: D3040 - Distribution Systems

Location: Throughout Building
Distress: Beyond Service Life
Category: Deferred Maintenance
Priority: 3 - Necessary/Not Yet Critical (Years 2-5)
Correction: Renew System
Qty: 21,307.00
Unit of Measure: S.F.
Estimate: \$196,174.00
Assessor Name: Somnath Das
Date Created: 02/07/2017

Notes: The distribution system is beyond its service life and should be replaced.

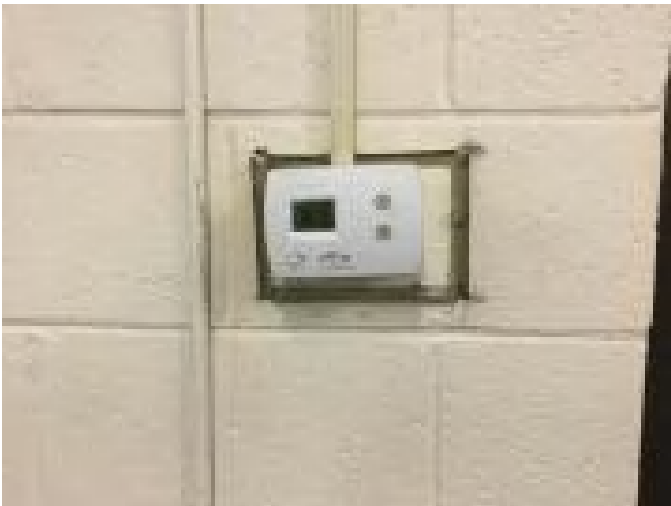
System: D3060 - Controls & Instrumentation

Location: Throughout Building
Distress: Beyond Service Life
Category: Deferred Maintenance
Priority: 3 - Necessary/Not Yet Critical (Years 2-5)
Correction: Renew System
Qty: 21,307.00
Unit of Measure: S.F.
Estimate: \$63,516.00
Assessor Name: Somnath Das
Date Created: 02/07/2017

Notes: The controls and instrumentation system is beyond its service life and should be replaced.

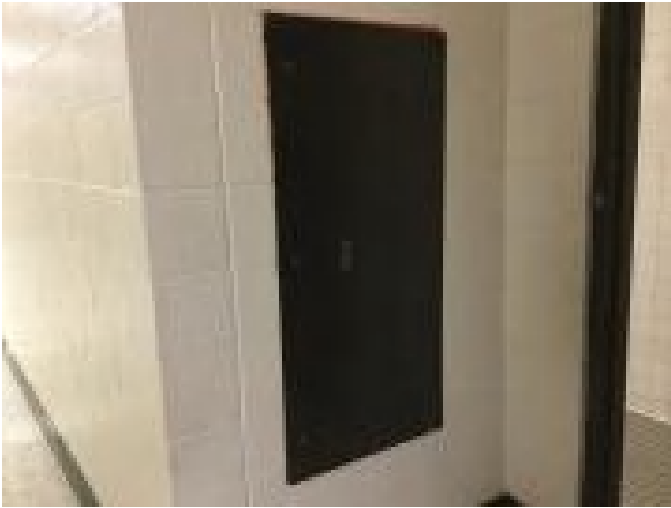
System: D5020 - Branch Wiring

Location: Throughout Building
Distress: Beyond Service Life
Category: Deferred Maintenance
Priority: 3 - Necessary/Not Yet Critical (Years 2-5)
Correction: Renew System
Qty: 21,307.00
Unit of Measure: S.F.
Estimate: \$108,985.00
Assessor Name: Somnath Das
Date Created: 02/07/2017

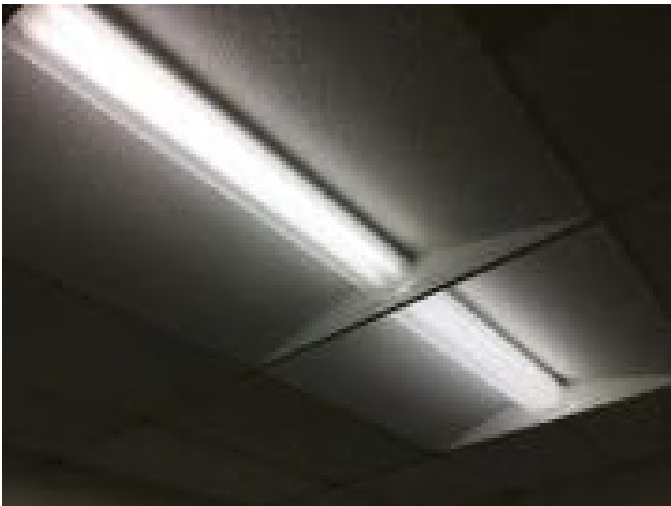
System: D5020 - Lighting

Location: Throughout Building
Distress: Beyond Service Life
Category: Deferred Maintenance
Priority: 3 - Necessary/Not Yet Critical (Years 2-5)
Correction: Renew System
Qty: 21,307.00
Unit of Measure: S.F.
Estimate: \$254,299.00
Assessor Name: Somnath Das
Date Created: 02/07/2017

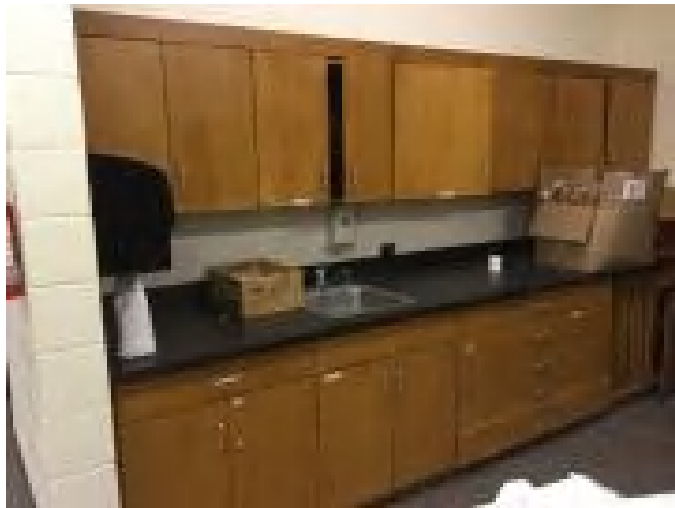
System: E2010 - Fixed Furnishings

Location: Throughout Building
Distress: Beyond Service Life
Category: Deferred Maintenance
Priority: 3 - Necessary/Not Yet Critical (Years 2-5)
Correction: Renew System
Qty: 21,307.00
Unit of Measure: S.F.
Estimate: \$119,064.00
Assessor Name: Somnath Das
Date Created: 02/07/2017

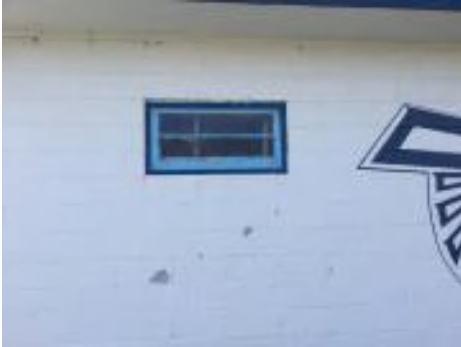
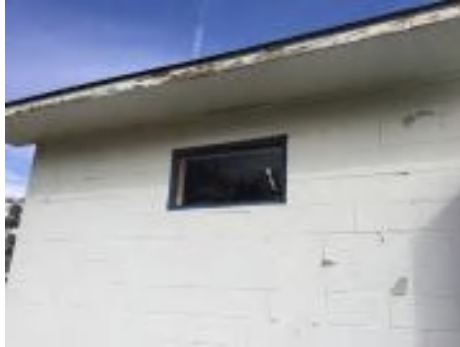
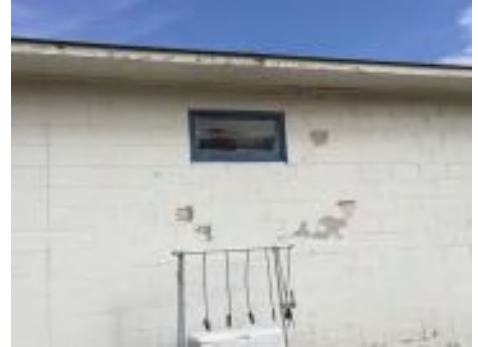
System: B2020 - Exterior Windows

Note: The exterior windows are beyond their service life and should be replaced.

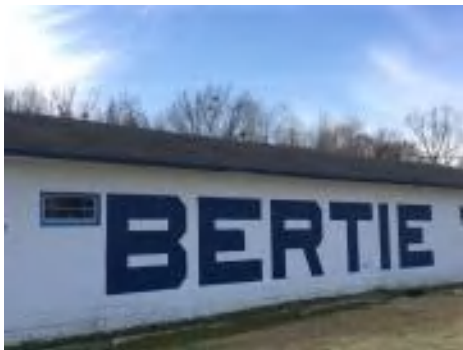
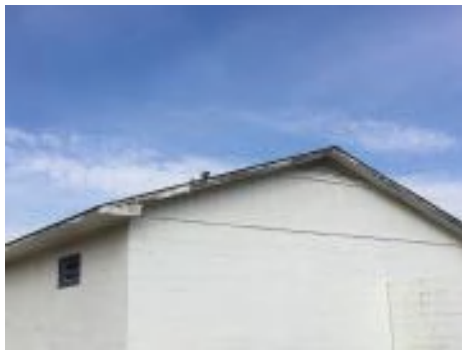
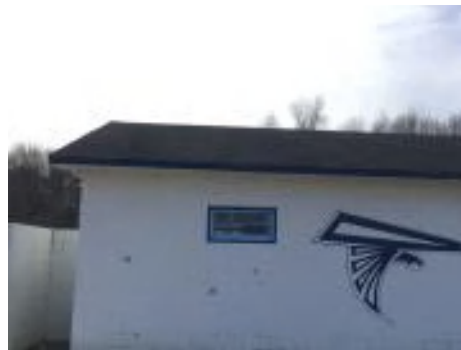
System: B3010140 - Asphalt Shingles

Note: The roof covering is beyond its service life and should be replaced.

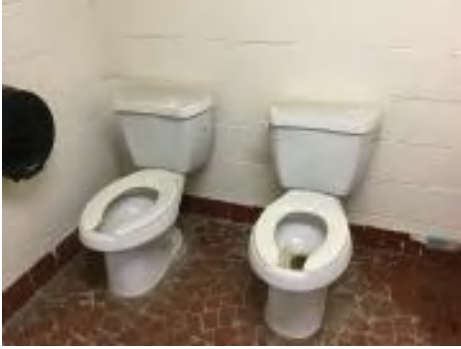
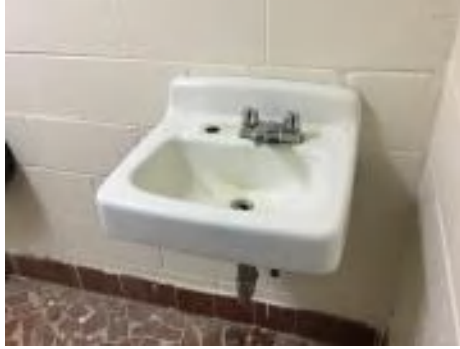
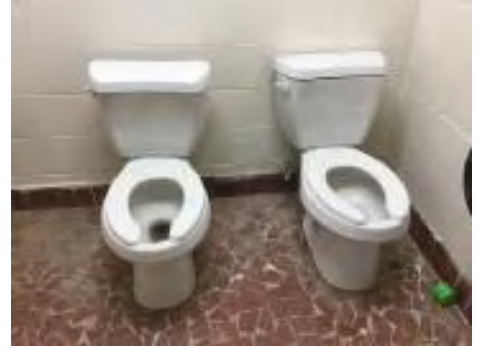
System: D2010 - Plumbing Fixtures

Note: The plumbing fixtures are beyond their service life and should be replaced.

Notes: The plumbing fixtures are beyond their service life and should be replaced.

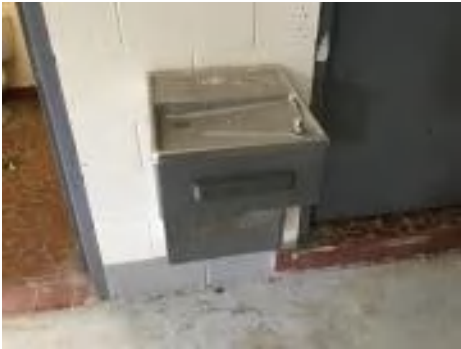
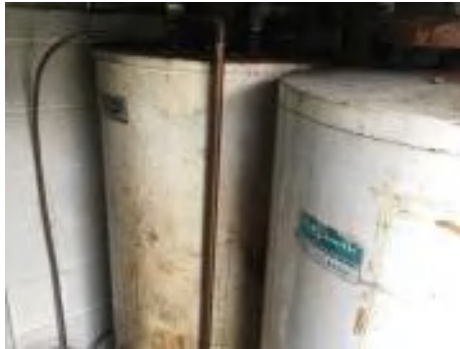
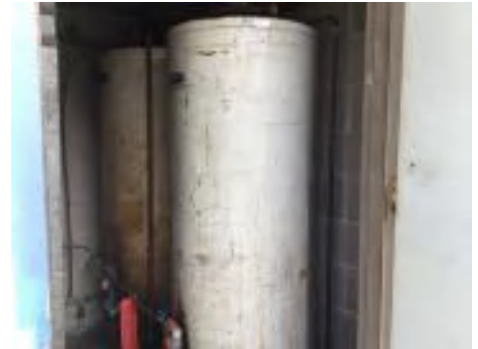
System: D2020 - Domestic Water Distribution

Note: The domestic water distribution system is beyond its service life and should be replaced.

Notes: The domestic water distribution system is beyond its service life and should be replaced.

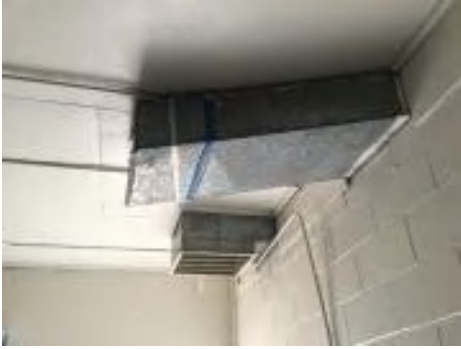
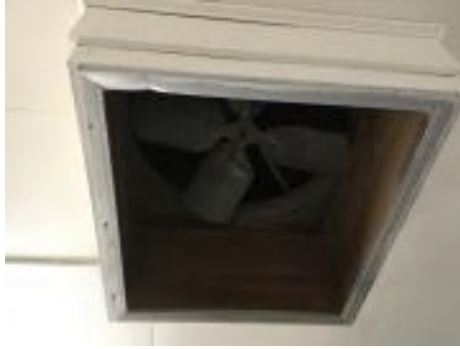
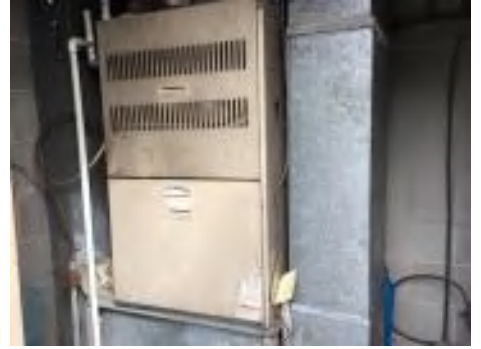
System: D3040 - Distribution Systems

Note: The distribution system is beyond its service life and should be replaced.

Notes: The distribution system is beyond its service life and should be replaced.

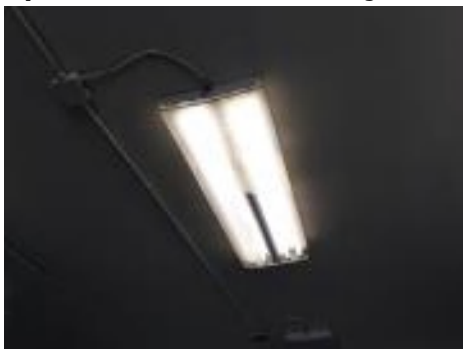
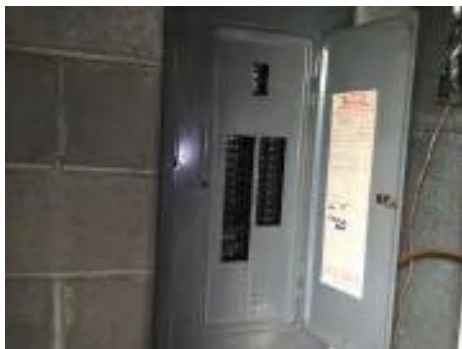
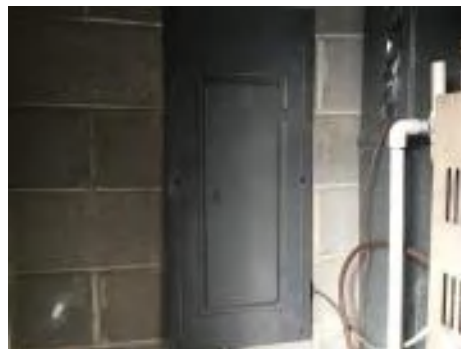
System: D5020 - Branch Wiring

Note: The branch wiring system is beyond its service life and should be replaced.

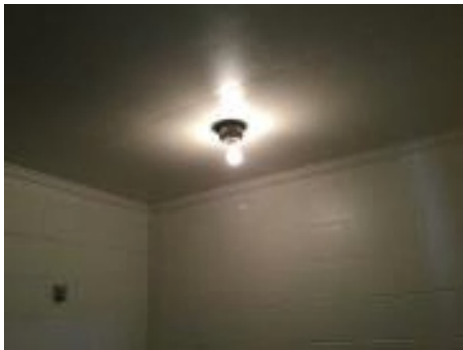
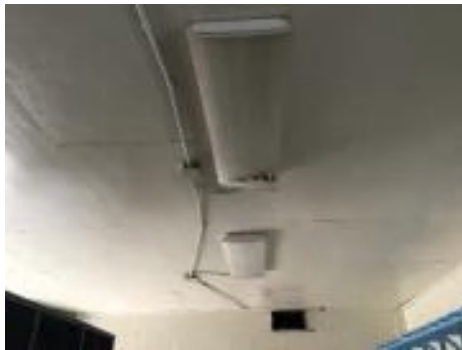
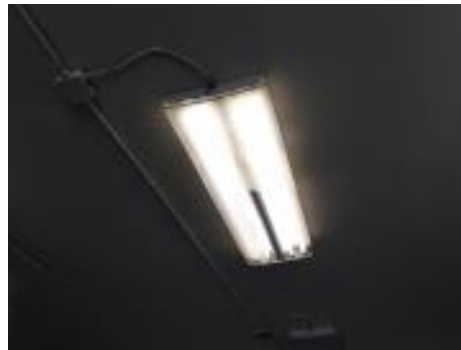
System: D5020 - Lighting

Note: The lighting system is beyond its service life and should be replaced.

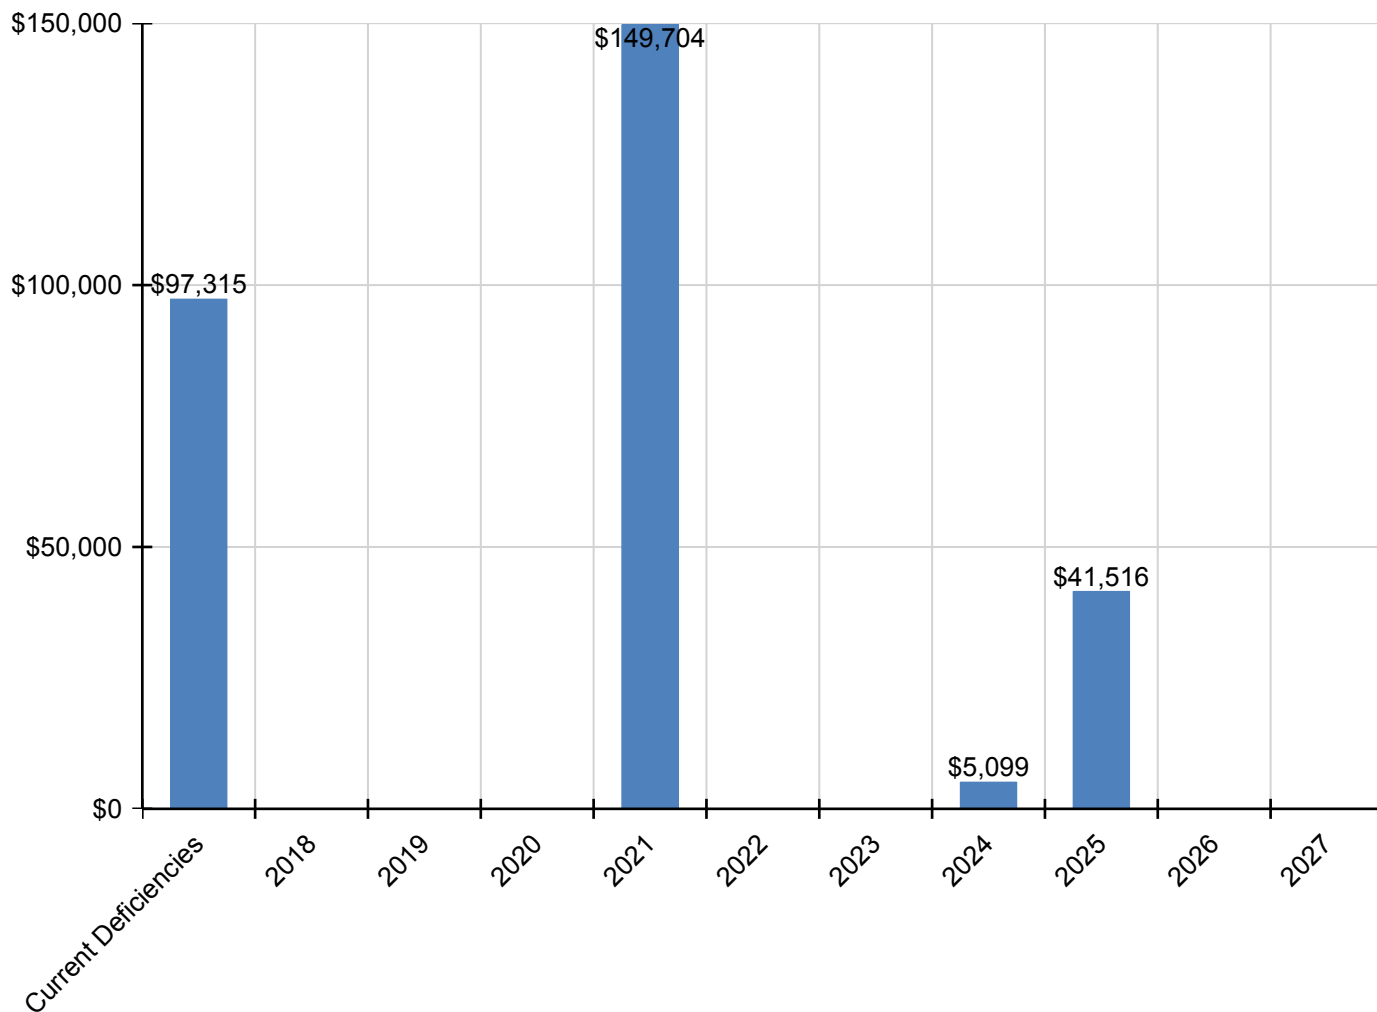
Forecasted Capital Renewal Requirement

The following chart shows the current building deficiencies and forecasting capital renewal or sustainment requirements over the next ten years.

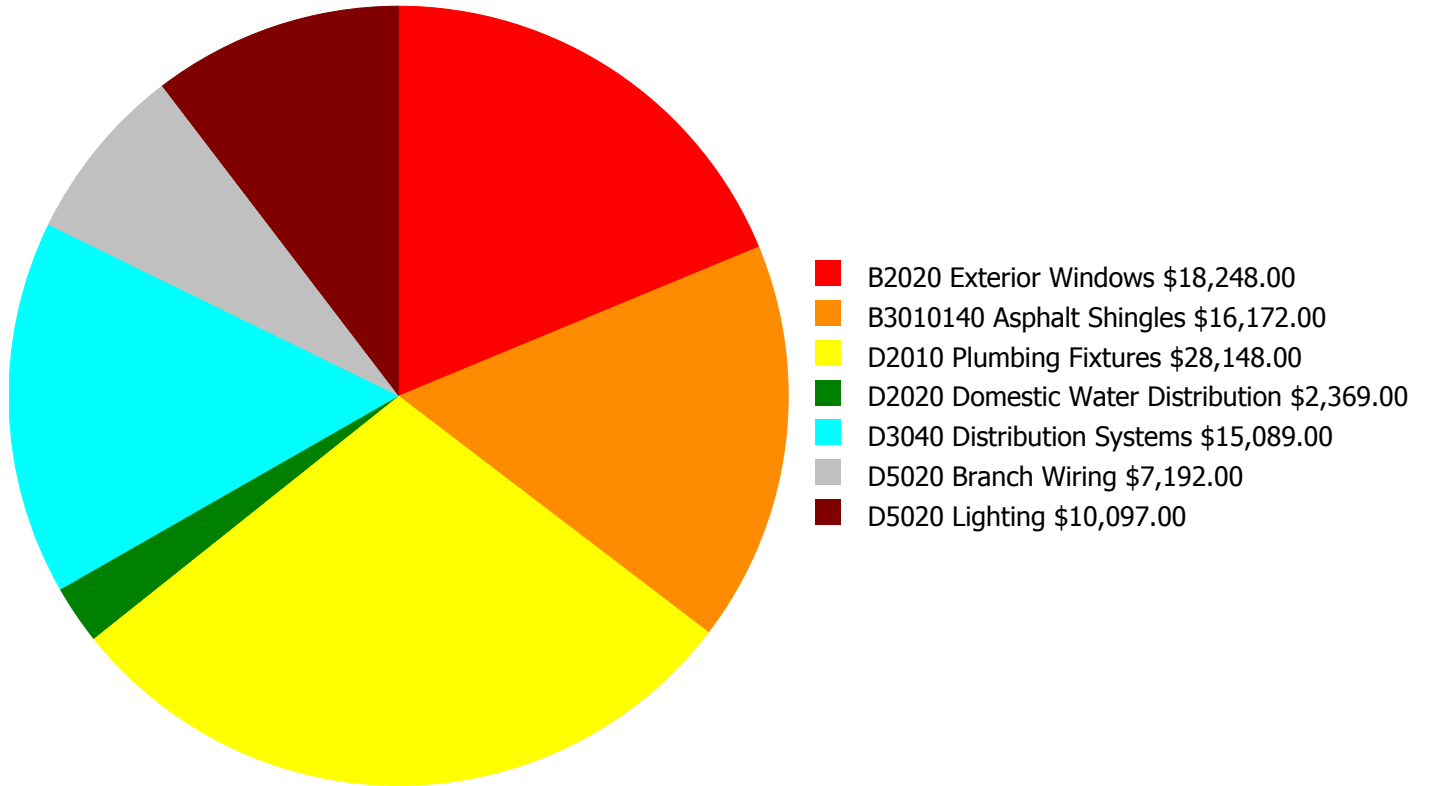
Deficiency Summary by System

Current deficiencies included assemblies that have reached or exceeded their design life or components of the assemblies that are in need of repair. Assemblies that have reached their design life are identified as current deficiencies and assigned the distress 'Beyond Useful Life'. The following chart lists all current deficiencies associated with this facility.

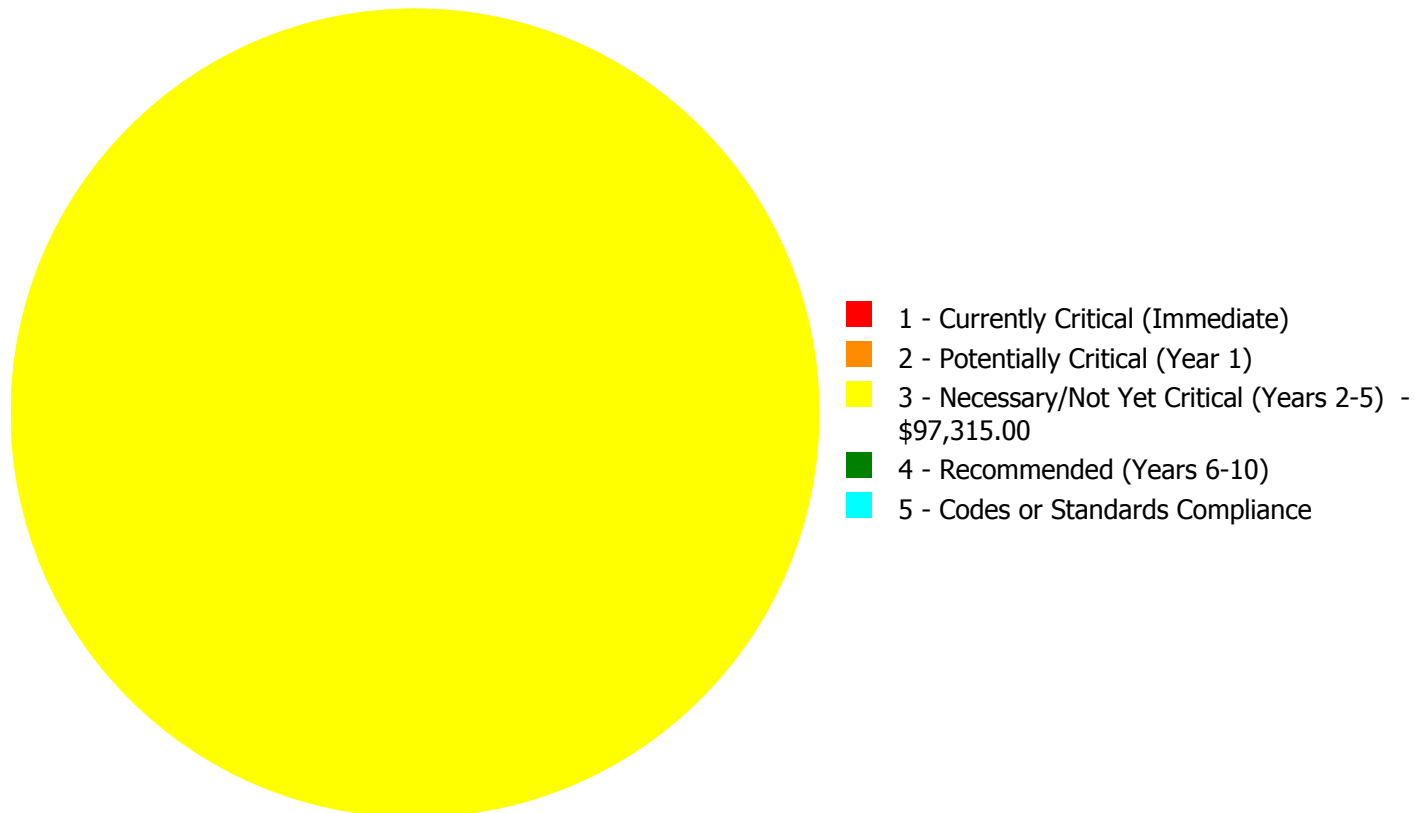
The following chart shows the total repair costs broken down by priority. Assessors assigned deficiencies within eCOMET to one of the following priority categories:

Budget Estimate Total: \$97,315.00

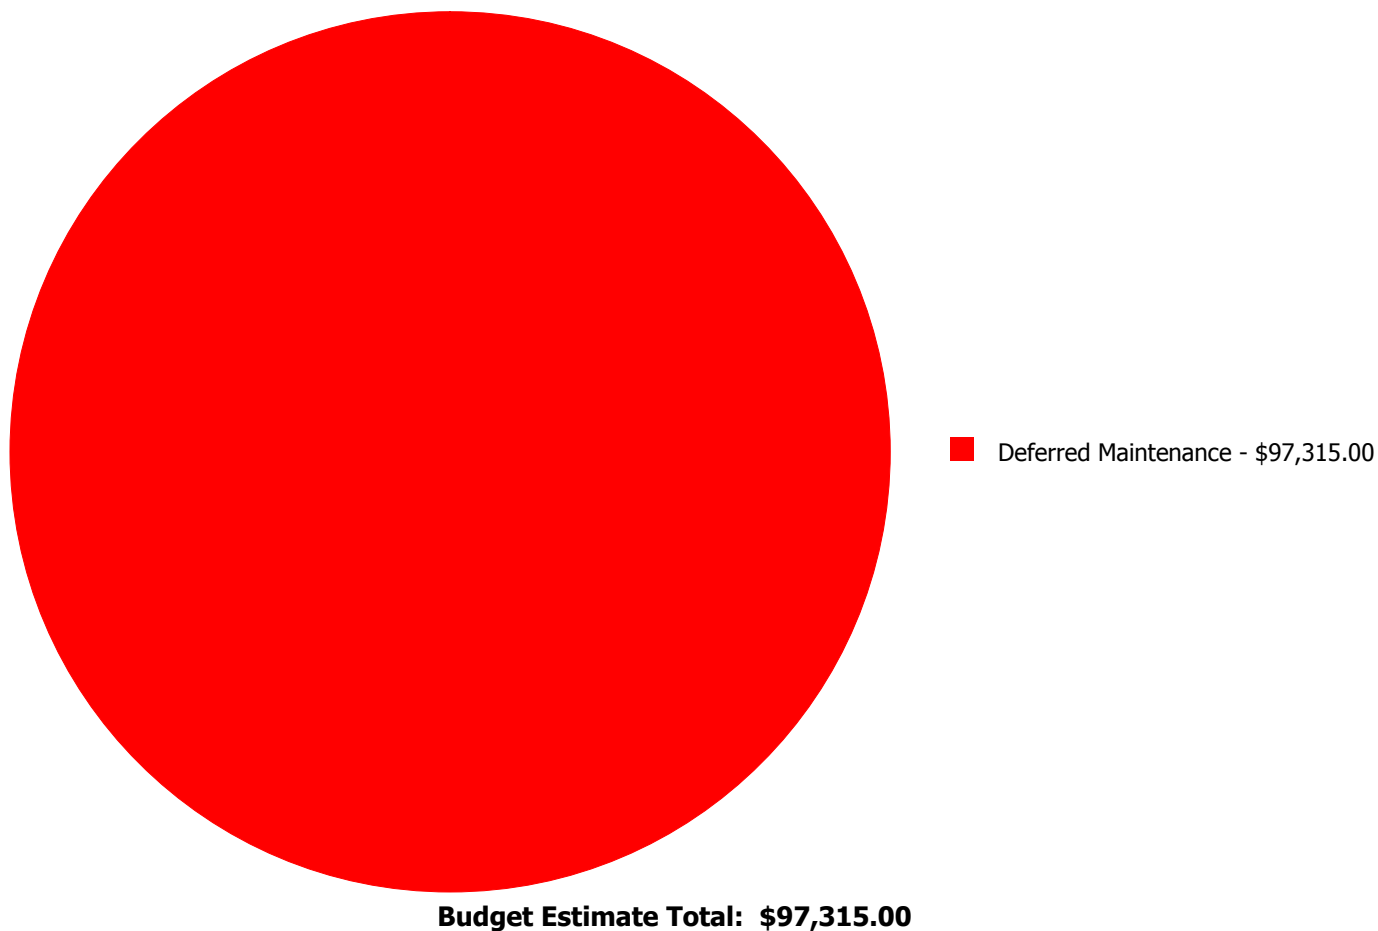
The following chart shows the total repair costs broken down by deficiency categories. Assessors assigned deficiencies to one of the following categories:

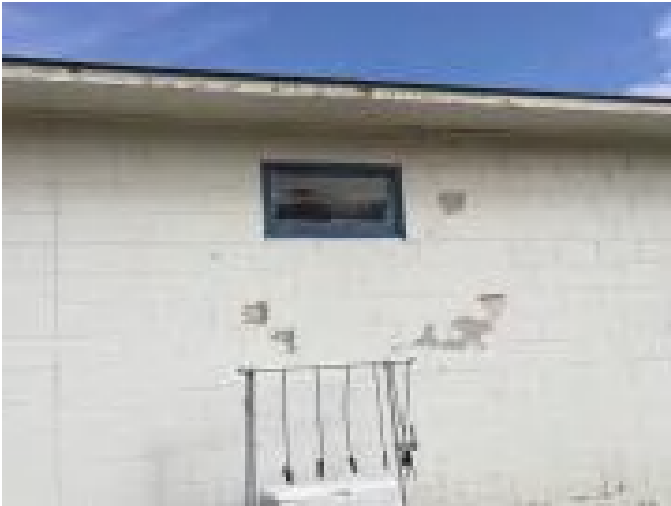
System: B2020 - Exterior Windows

Location: Exterior Walls
Distress: Beyond Service Life
Category: Deferred Maintenance
Priority: 3 - Necessary/Not Yet Critical (Years 2-5)
Correction: Renew System
Qty: 2,564.00
Unit of Measure: S.F.
Estimate: \$18,248.00
Assessor Name: Eduardo Lopez
Date Created: 02/08/2017

Notes: The exterior windows are beyond their service life and should be replaced.

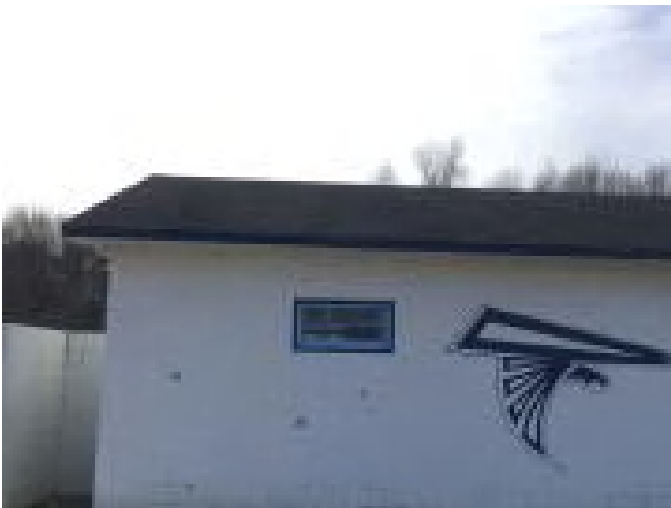
System: B3010140 - Asphalt Shingles

Location: Roof
Distress: Beyond Service Life
Category: Deferred Maintenance
Priority: 3 - Necessary/Not Yet Critical (Years 2-5)
Correction: Renew System
Qty: 2,564.00
Unit of Measure: S.F.
Estimate: \$16,172.00
Assessor Name: Eduardo Lopez
Date Created: 02/08/2017

Notes: The roof covering is beyond its service life and should be replaced.
