NC School District/080 Bertie County/Middle School

Bertie Middle

Campus Assessment Report

March 8, 2017

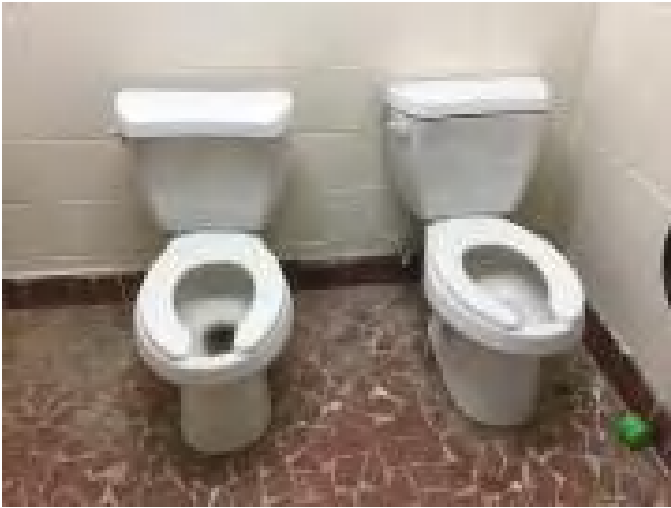
System: D2010 - Plumbing Fixtures

Location: Throughout Building
Distress: Beyond Service Life
Category: Deferred Maintenance
Priority: 3 - Necessary/Not Yet Critical (Years 2-5)
Correction: Renew System
Qty: 2,564.00
Unit of Measure: S.F.
Estimate: \$28,148.00
Assessor Name: Eduardo Lopez
Date Created: 02/08/2017

Notes: The plumbing fixtures are beyond their service life and should be replaced.

Note: The plumbing fixtures are beyond their service life and should be replaced.

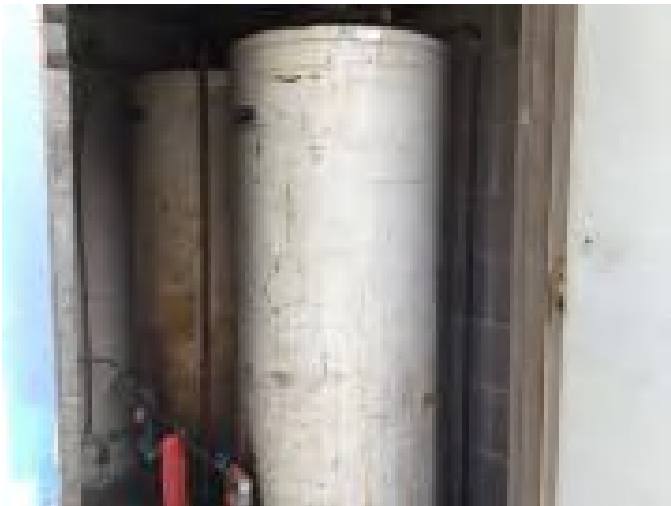
System: D2020 - Domestic Water Distribution

Location: Throughout Building
Distress: Beyond Service Life
Category: Deferred Maintenance
Priority: 3 - Necessary/Not Yet Critical (Years 2-5)
Correction: Renew System
Qty: 2,564.00
Unit of Measure: S.F.
Estimate: \$2,369.00
Assessor Name: Eduardo Lopez
Date Created: 02/08/2017

Notes: The domestic water distribution system is beyond its service life and should be replaced.

Note: The domestic water distribution system is beyond its service life and should be replaced.

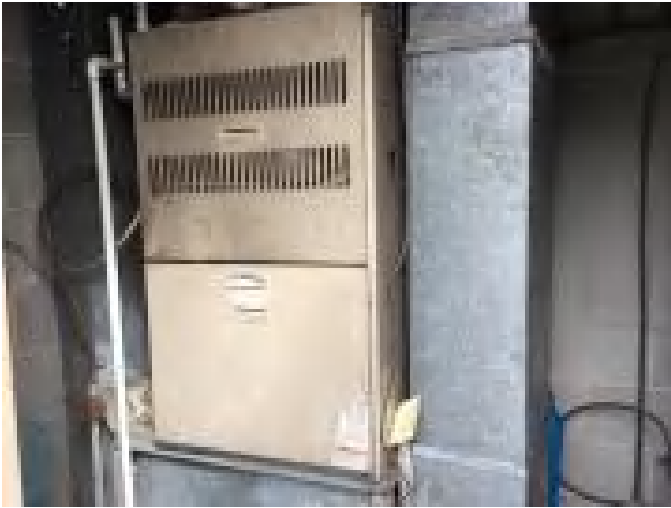
System: D3040 - Distribution Systems

Location: Throughout Building
Distress: Beyond Service Life
Category: Deferred Maintenance
Priority: 3 - Necessary/Not Yet Critical (Years 2-5)
Correction: Renew System
Qty: 2,564.00
Unit of Measure: S.F.
Estimate: \$15,089.00
Assessor Name: Eduardo Lopez
Date Created: 02/08/2017

Notes: The distribution system is beyond its service life and should be replaced.

Note: The distribution system is beyond its service life and should be replaced.

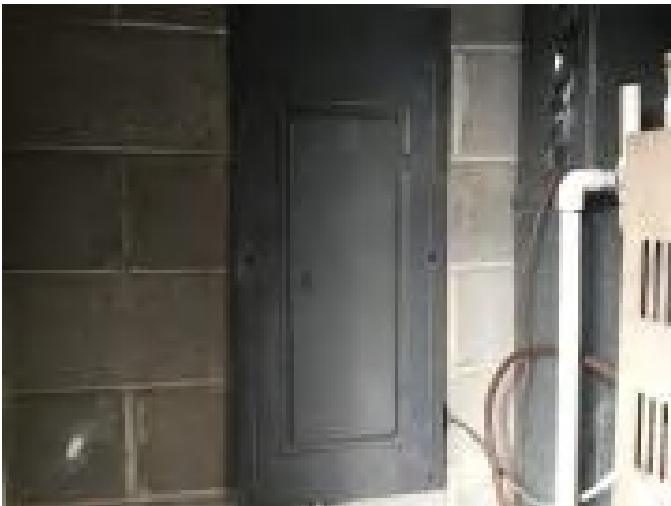
System: D5020 - Branch Wiring

Location: Throughout Building
Distress: Beyond Service Life
Category: Deferred Maintenance
Priority: 3 - Necessary/Not Yet Critical (Years 2-5)
Correction: Renew System
Qty: 2,564.00
Unit of Measure: S.F.
Estimate: \$7,192.00
Assessor Name: Eduardo Lopez
Date Created: 02/08/2017

Notes: The branch wiring system is beyond its service life and should be replaced.

Note: The branch wiring system is beyond its service life and should be replaced.

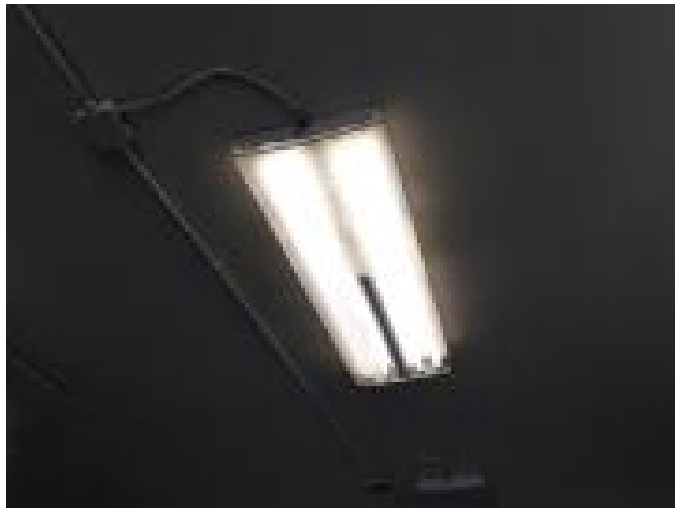
System: D5020 - Lighting

Location: Throughout Building
Distress: Beyond Service Life
Category: Deferred Maintenance
Priority: 3 - Necessary/Not Yet Critical (Years 2-5)
Correction: Renew System
Qty: 2,564.00
Unit of Measure: S.F.
Estimate: \$10,097.00
Assessor Name: Eduardo Lopez
Date Created: 02/08/2017

Notes: The lighting system is beyond its service life and should be replaced.

Note: The lighting system is beyond its service life and should be replaced.

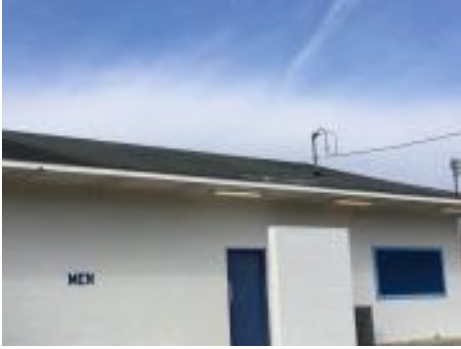
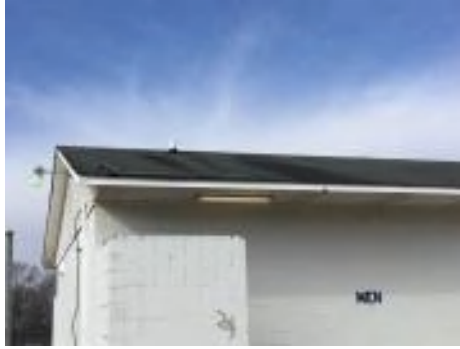
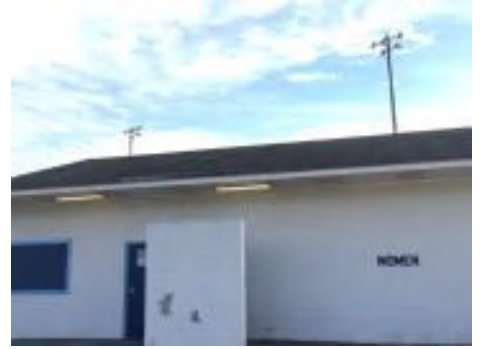
System: B3010140 - Asphalt Shingles

Note: The asphalt shingle tiles are beyond their service life and should be replaced.

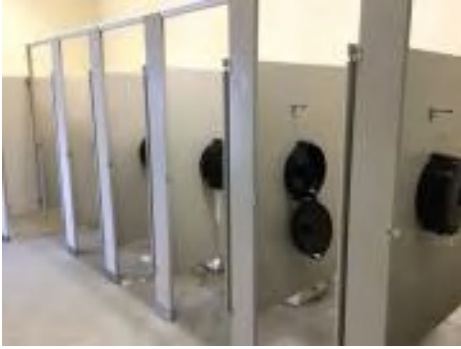
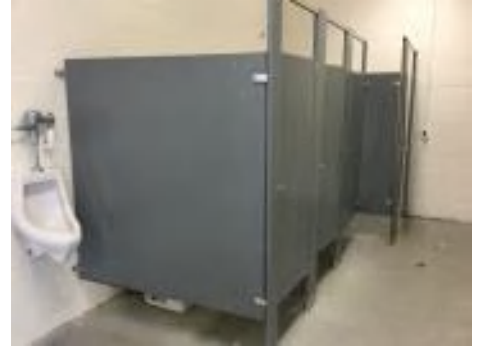
System: C1030 - Fittings

Note: The fittings are beyond their service life and should be replaced.

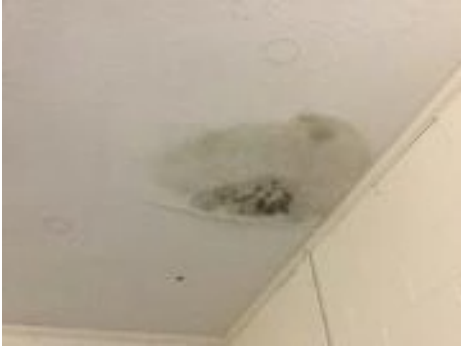
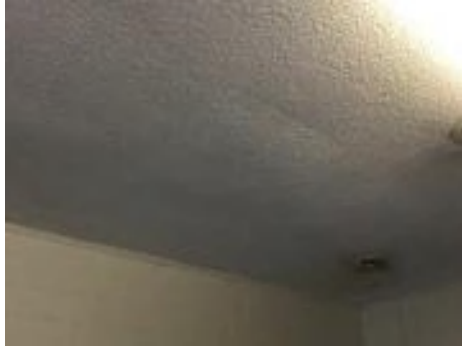
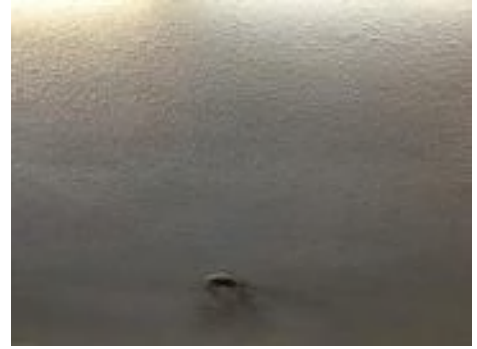
System: C3030 - Ceiling Finishes

Note: The ceiling finishes are beyond their service life and should be replaced.

Notes: The ceiling finishes are beyond their service life and should be replaced.

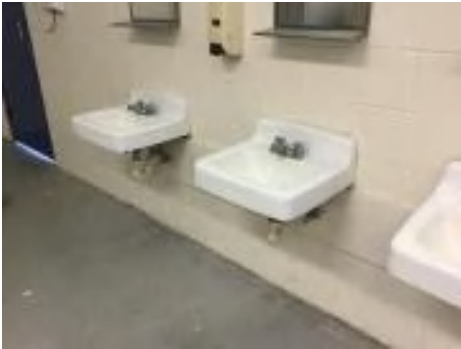
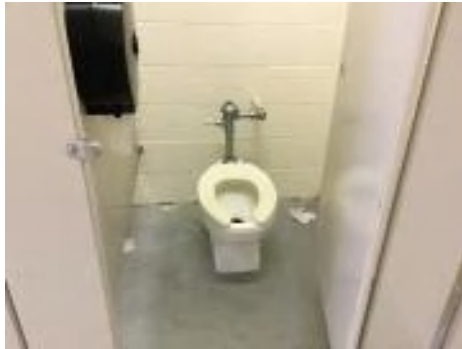
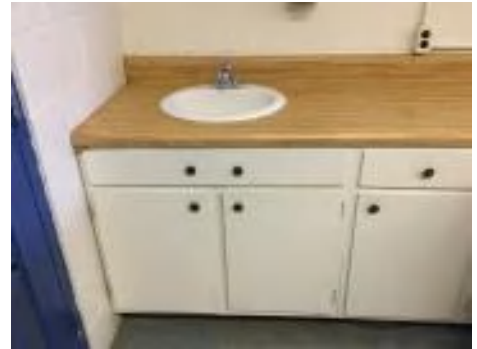
System: D2010 - Plumbing Fixtures

Note: The plumbing fixtures are beyond their service life and should be replaced.

Notes: The plumbing fixtures are beyond their service life and should be replaced.

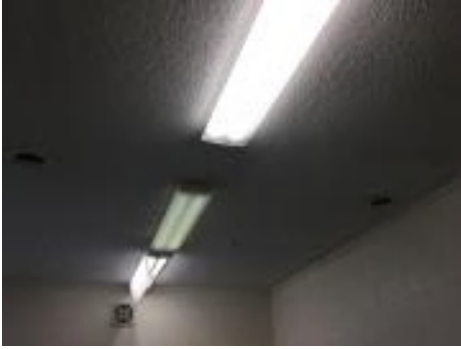
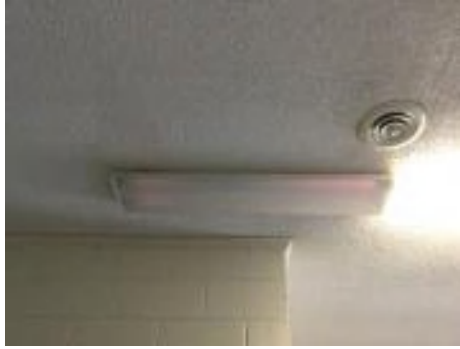
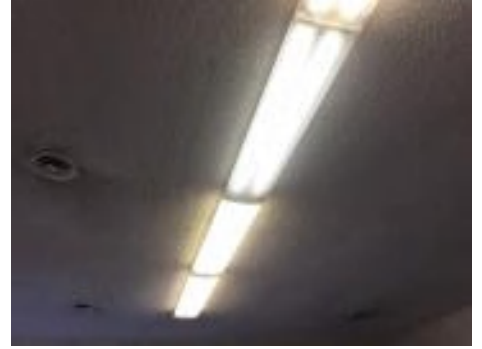
System: D5020 - Lighting

Note: The lighting system is beyond its service life and should be replaced.

Notes: The lighting system is beyond its service life and should be replaced.

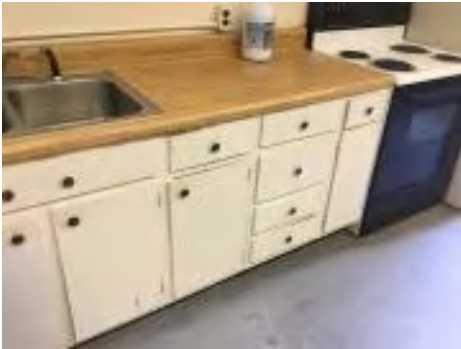
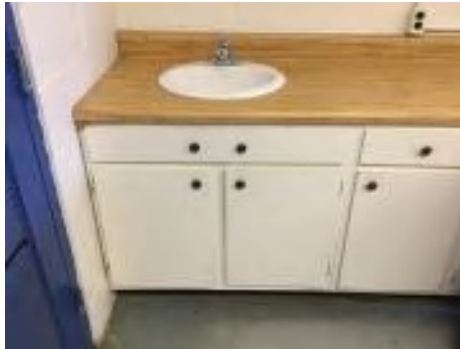
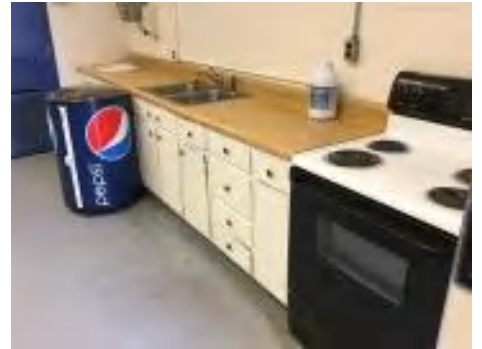
System: E2010 - Fixed Furnishings

Note: The fixed furnishings are beyond their service life and should be replaced.

Notes: The fixed furnishings are beyond their service life and should be replaced.

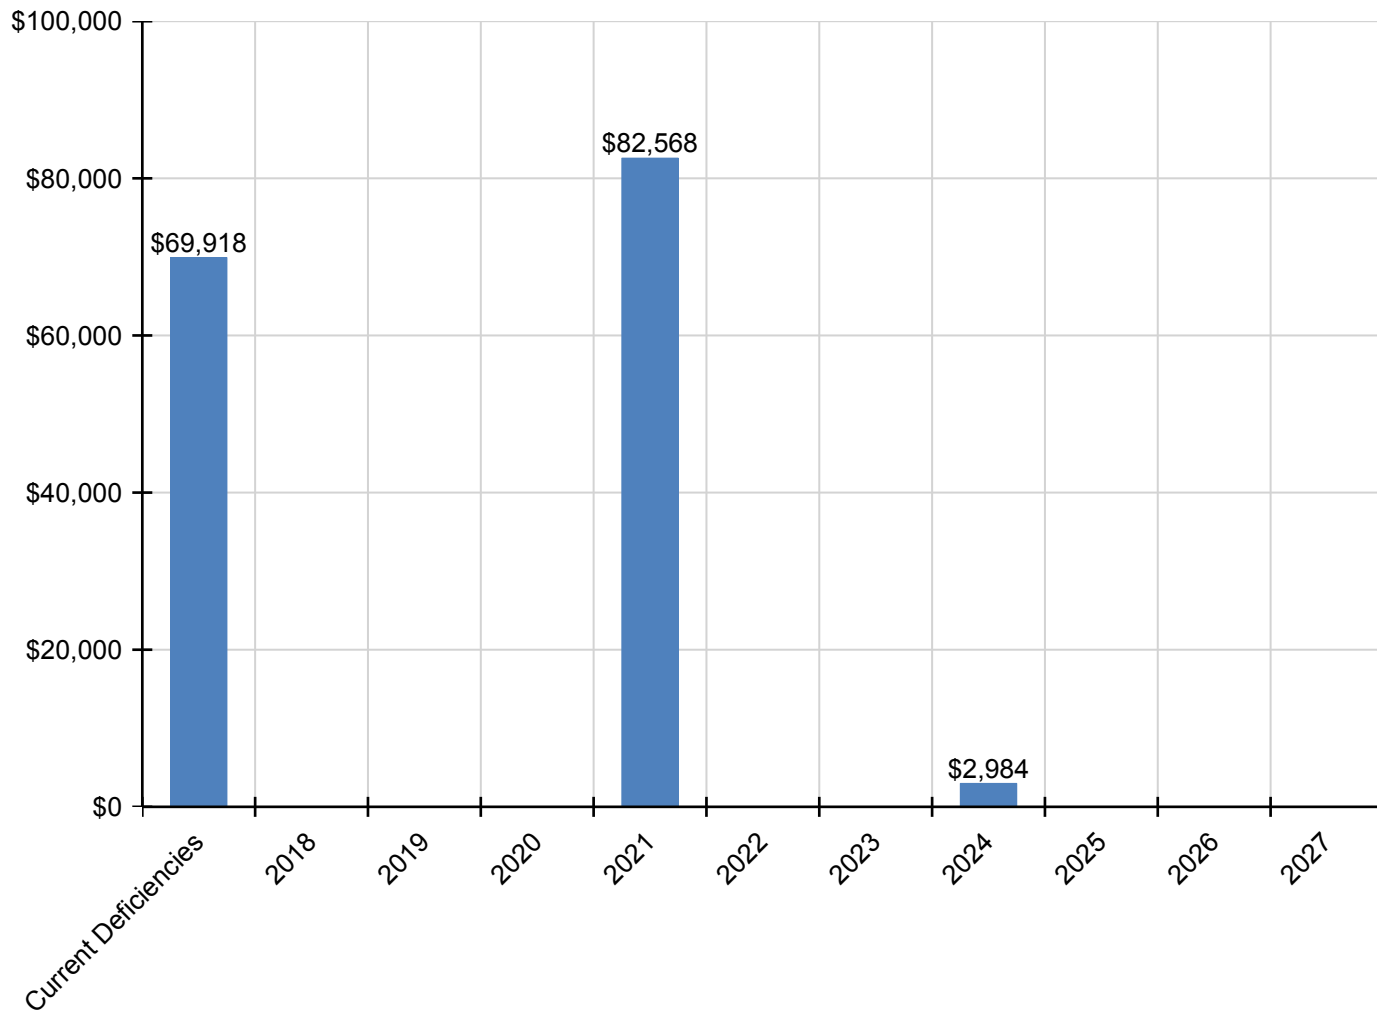
Forecasted Capital Renewal Requirement

The following chart shows the current building deficiencies and forecasting capital renewal or sustainment requirements over the next ten years.

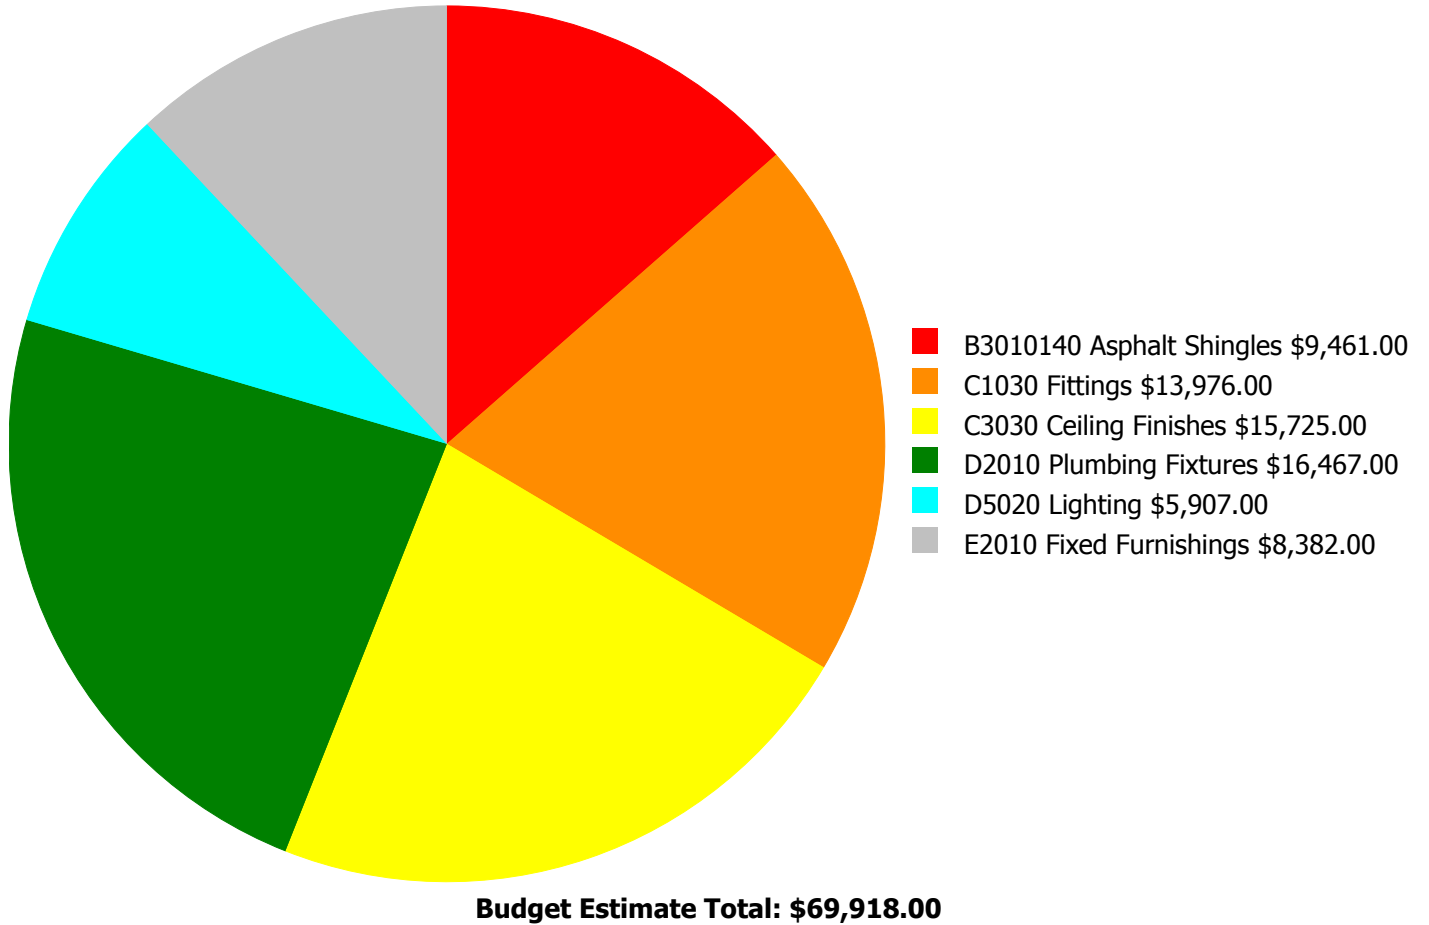
Deficiency Summary by System

Current deficiencies included assemblies that have reached or exceeded their design life or components of the assemblies that are in need of repair. Assemblies that have reached their design life are identified as current deficiencies and assigned the distress 'Beyond Useful Life'. The following chart lists all current deficiencies associated with this facility.

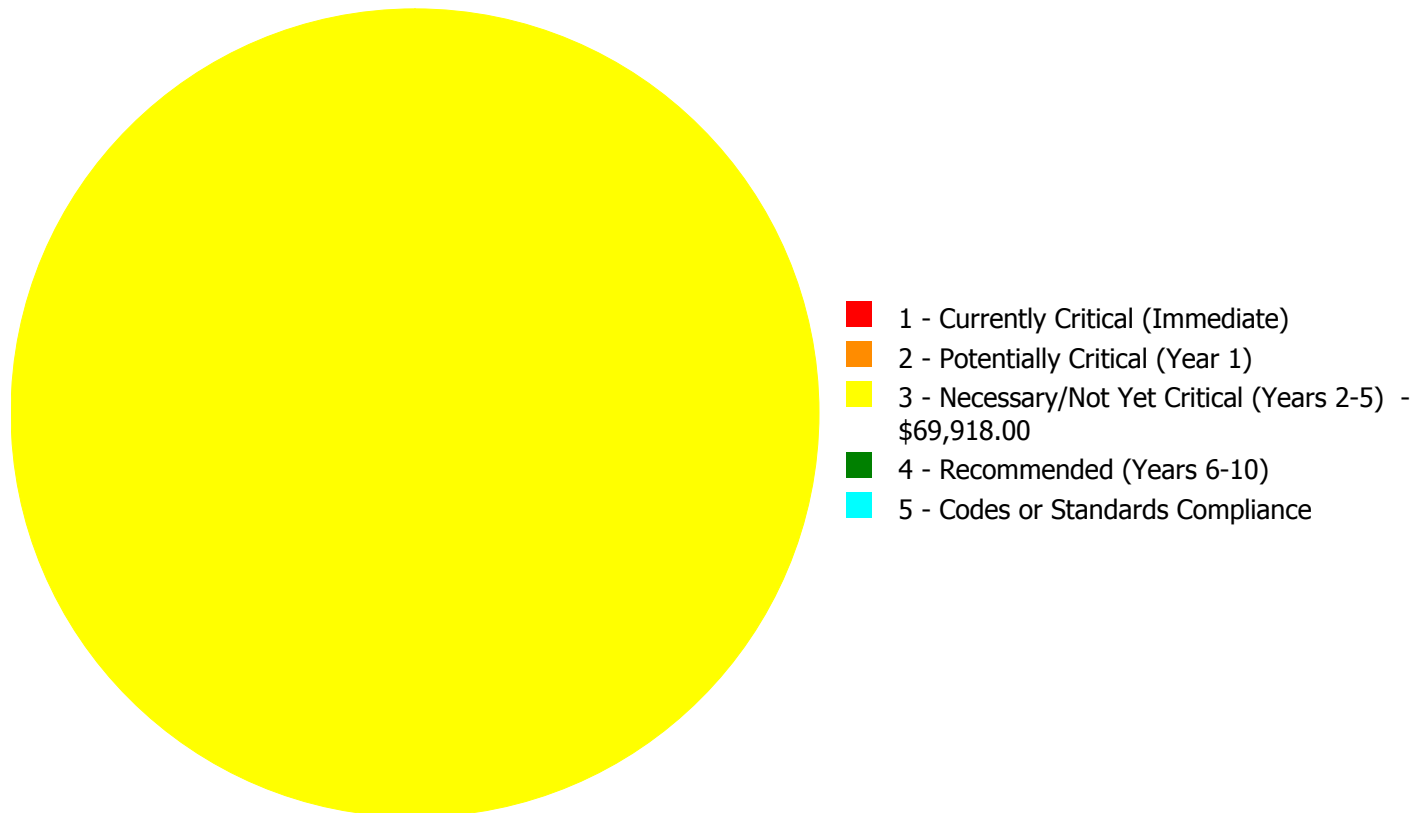
Deficiency Summary by Priority

The following chart shows the total repair costs broken down by priority. Assessors assigned deficiencies within eCOMET to one of the following priority categories:

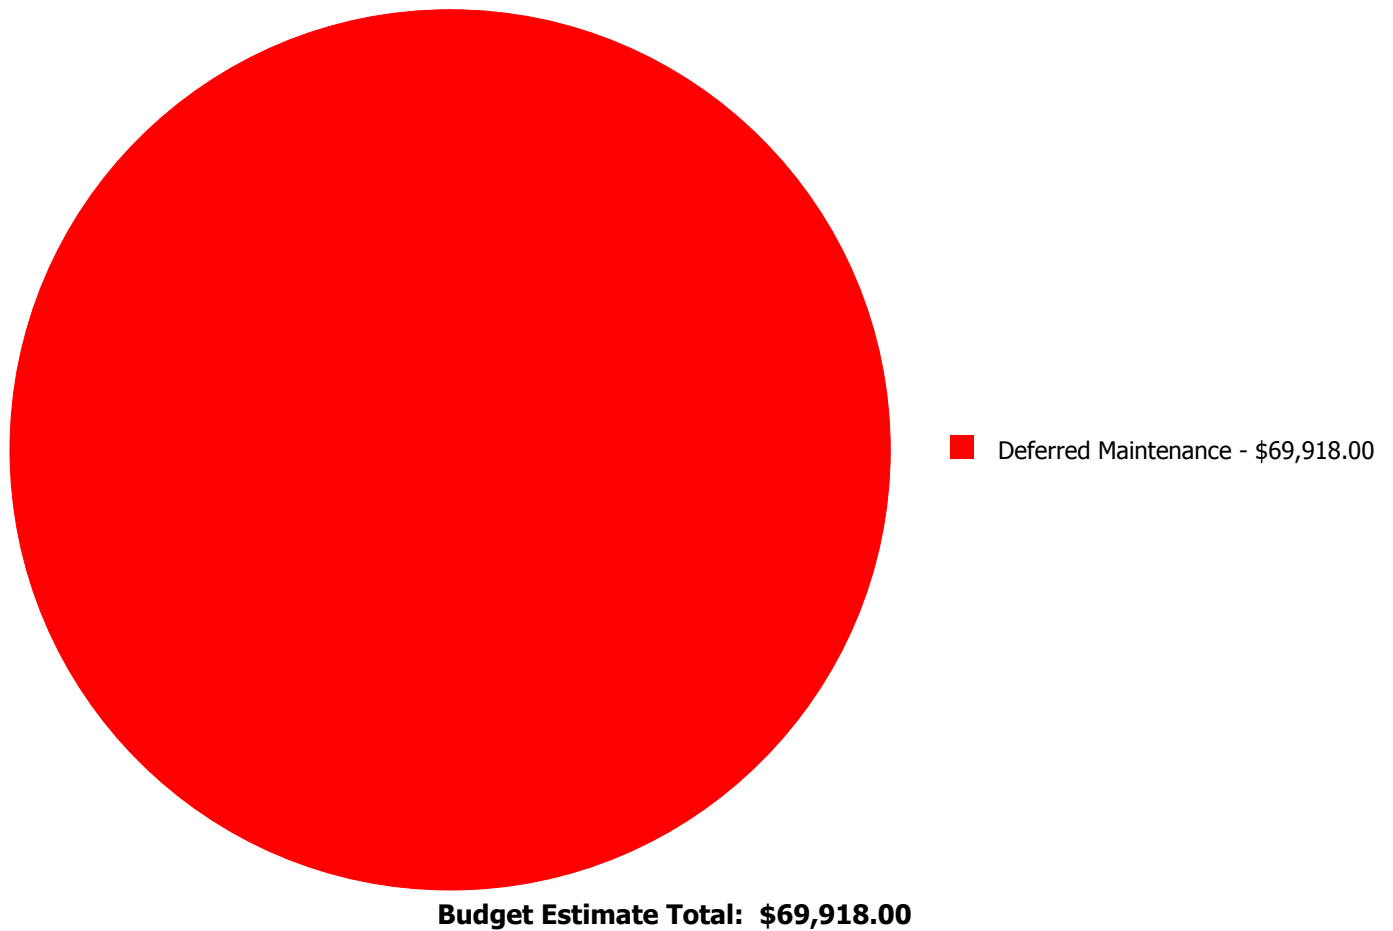
Deficiency Summary by Category

The following chart shows the total repair costs broken down by deficiency categories. Assessors assigned deficiencies to one of the following categories:

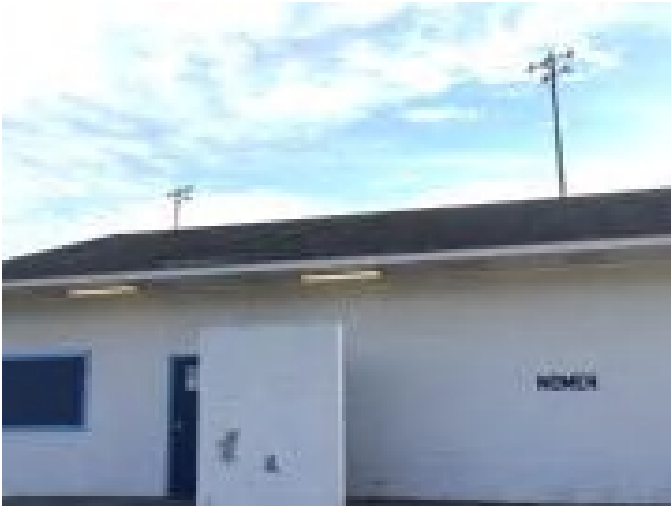
System: B3010140 - Asphalt Shingles

Location: Roof
Distress: Beyond Service Life
Category: Deferred Maintenance
Priority: 3 - Necessary/Not Yet Critical (Years 2-5)
Correction: Renew System
Qty: 1,500.00
Unit of Measure: S.F.
Estimate: \$9,461.00
Assessor Name: Eduardo Lopez
Date Created: 02/07/2017

Notes: The asphalt shingle tiles are beyond their service life and should be replaced.

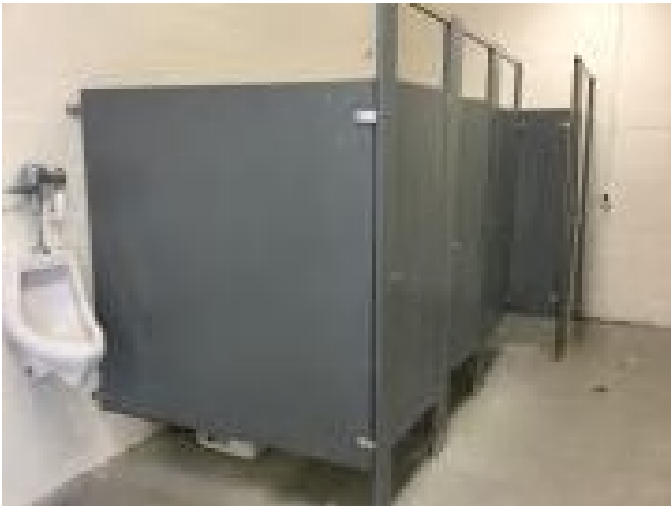
System: C1030 - Fittings

Location: Throughout Building
Distress: Beyond Service Life
Category: Deferred Maintenance
Priority: 3 - Necessary/Not Yet Critical (Years 2-5)
Correction: Renew System
Qty: 1,500.00
Unit of Measure: S.F.
Estimate: \$13,976.00
Assessor Name: Eduardo Lopez
Date Created: 02/07/2017

Notes: The fittings are beyond their service life and should be replaced.

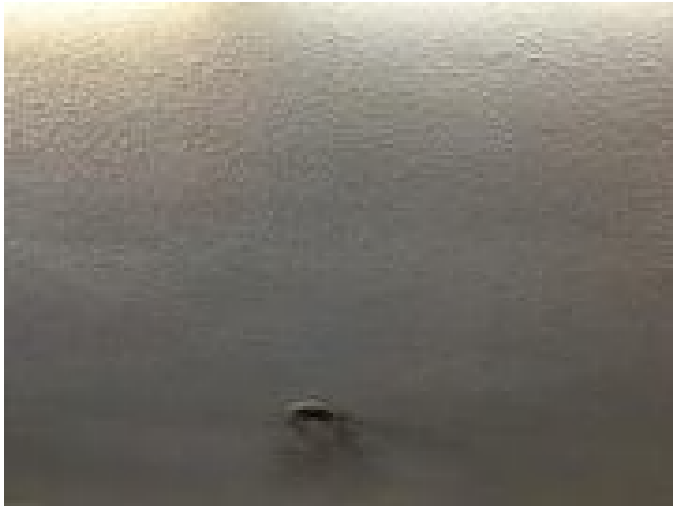
System: C3030 - Ceiling Finishes

Location: Throughout Building
Distress: Beyond Service Life
Category: Deferred Maintenance
Priority: 3 - Necessary/Not Yet Critical (Years 2-5)
Correction: Renew System
Qty: 1,500.00
Unit of Measure: S.F.
Estimate: \$15,725.00
Assessor Name: Eduardo Lopez
Date Created: 02/07/2017

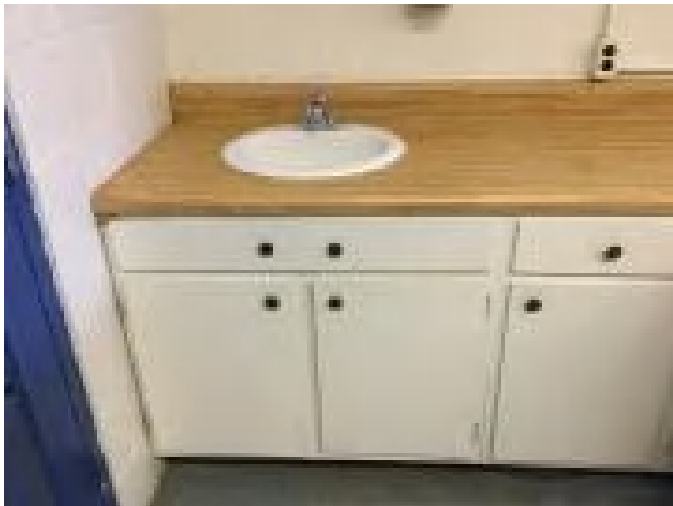
System: D2010 - Plumbing Fixtures

Location: Throughout Building
Distress: Beyond Service Life
Category: Deferred Maintenance
Priority: 3 - Necessary/Not Yet Critical (Years 2-5)
Correction: Renew System
Qty: 1,500.00
Unit of Measure: S.F.
Estimate: \$16,467.00
Assessor Name: Eduardo Lopez
Date Created: 02/07/2017

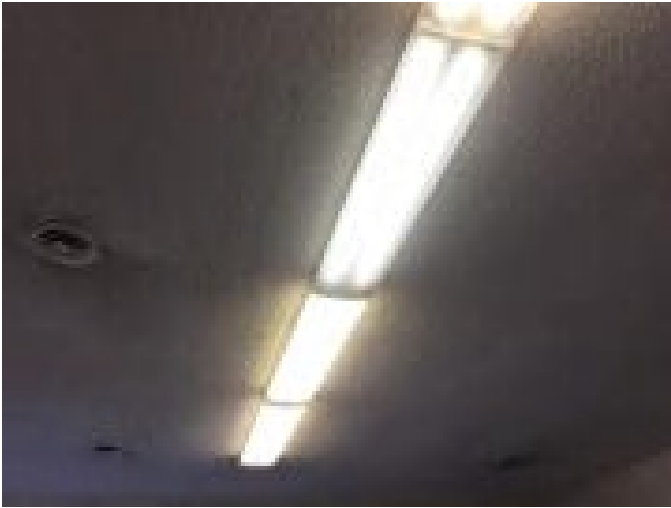
System: D5020 - Lighting

Location: Throughout Building
Distress: Beyond Service Life
Category: Deferred Maintenance
Priority: 3 - Necessary/Not Yet Critical (Years 2-5)
Correction: Renew System
Qty: 1,500.00
Unit of Measure: S.F.
Estimate: \$5,907.00
Assessor Name: Eduardo Lopez
Date Created: 02/07/2017

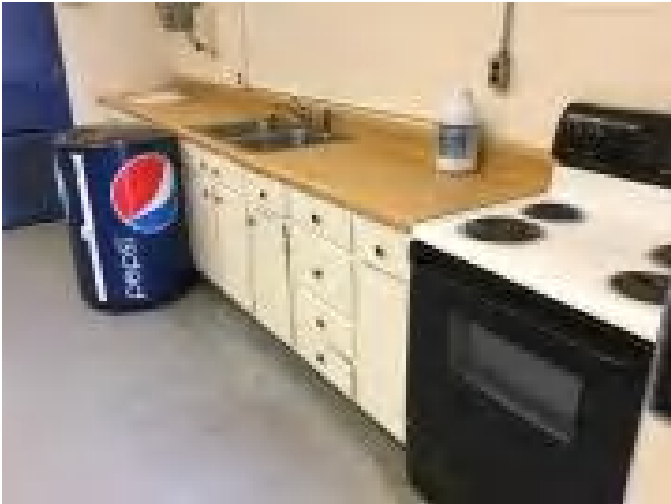
System: E2010 - Fixed Furnishings

Location: Throughout Building
Distress: Beyond Service Life
Category: Deferred Maintenance
Priority: 3 - Necessary/Not Yet Critical (Years 2-5)
Correction: Renew System
Qty: 1,500.00
Unit of Measure: S.F.
Estimate: \$8,382.00
Assessor Name: Eduardo Lopez
Date Created: 02/07/2017

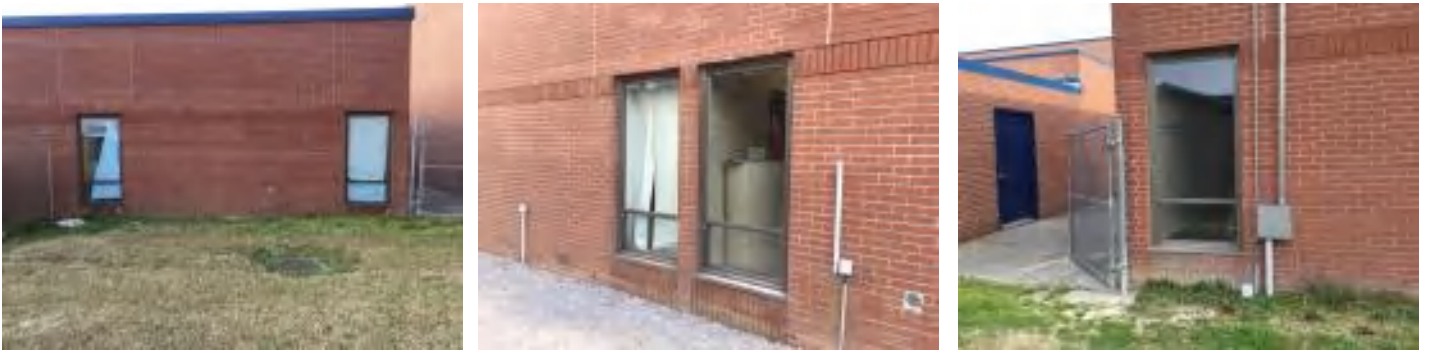
System: B2020 - Exterior Windows

Note: The exterior windows are beyond their service life and should be replaced.

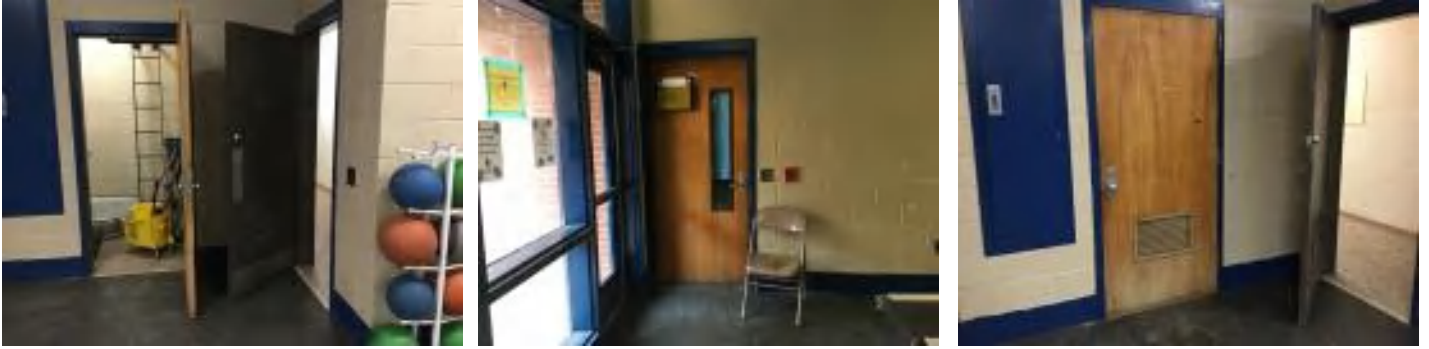
System: C1020 - Interior Doors

Note: The interior doors are beyond their service life and should be replaced.

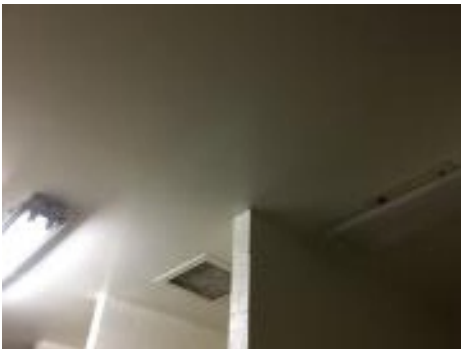
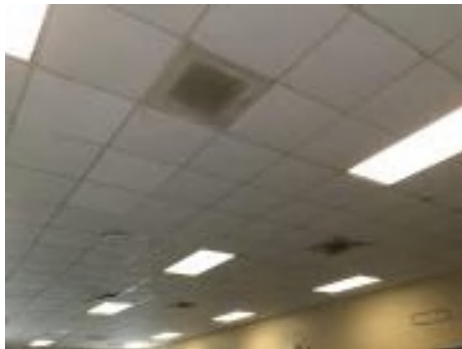
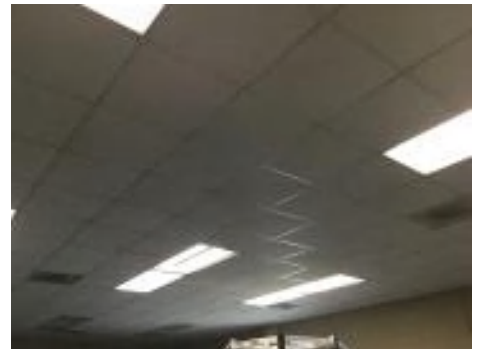
System: C3030 - Ceiling Finishes

Note: The ceiling finishes are beyond their service life and should be replaced.

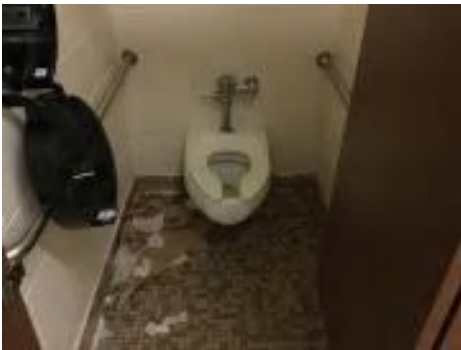
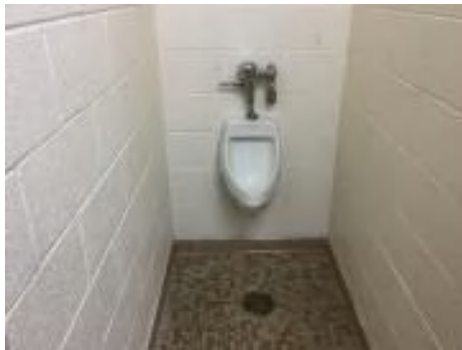
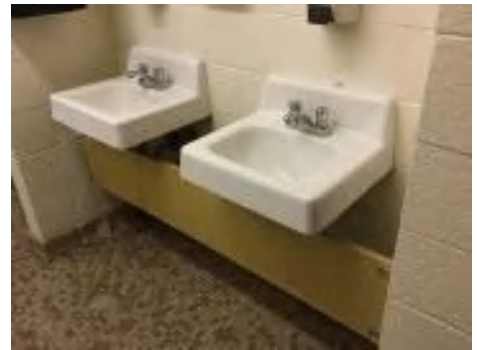
System: D2010 - Plumbing Fixtures

Note: The plumbing fixtures are beyond their service life and should be replaced.

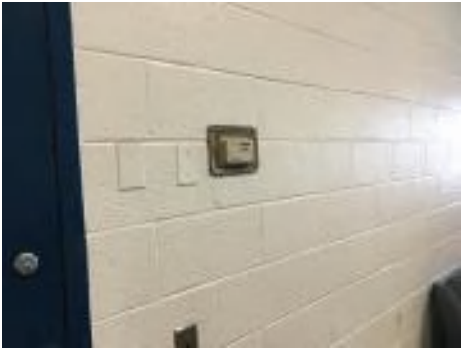
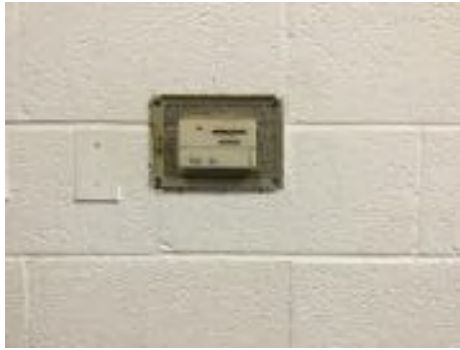
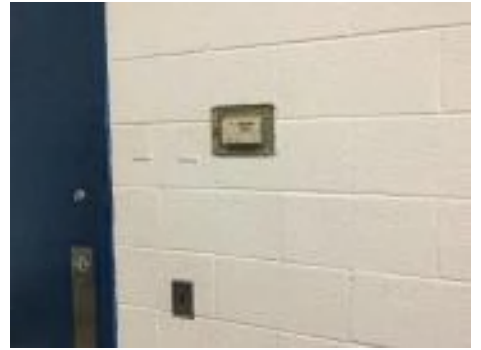
System: D3060 - Controls & Instrumentation

Note: The controls and instrumentation system is beyond its service life and should be replaced.

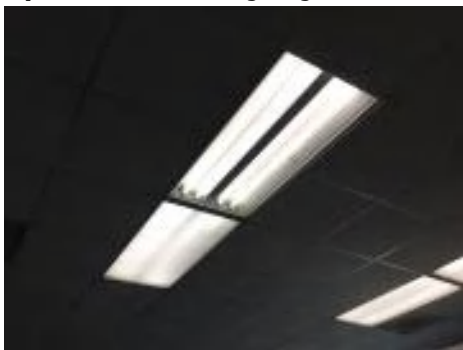
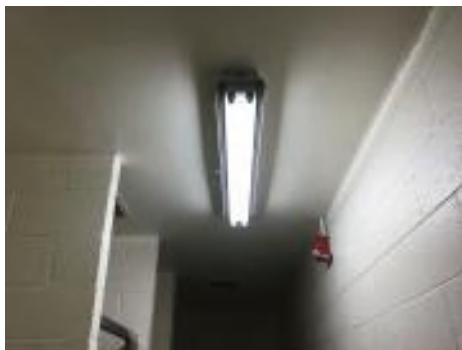
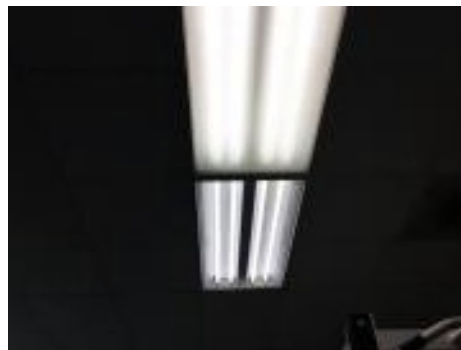
System: D5020 - Lighting

Note: The lighting system is beyond its service life and should be replaced.

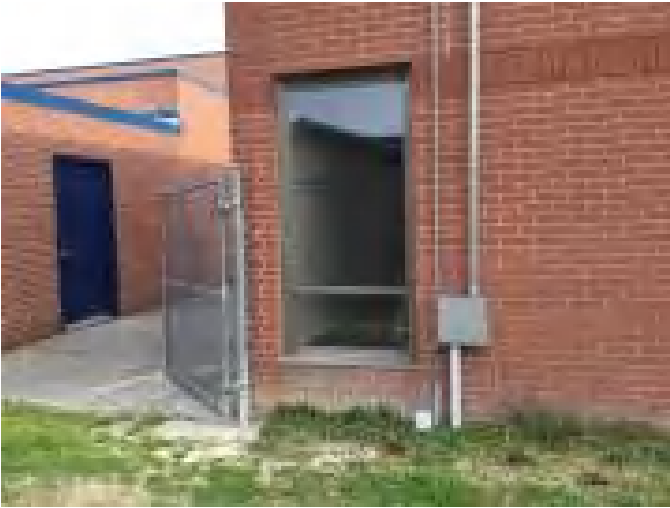
System: B2020 - Exterior Windows

Location: Exterior Walls
Distress: Beyond Service Life
Category: Deferred Maintenance
Priority: 3 - Necessary/Not Yet Critical (Years 2-5)
Correction: Renew System
Qty: 6,018.00
Unit of Measure: S.F.
Estimate: \$86,322.00
Assessor Name: Somnath Das
Date Created: 02/08/2017

Notes: The exterior windows are beyond their service life and should be replaced.

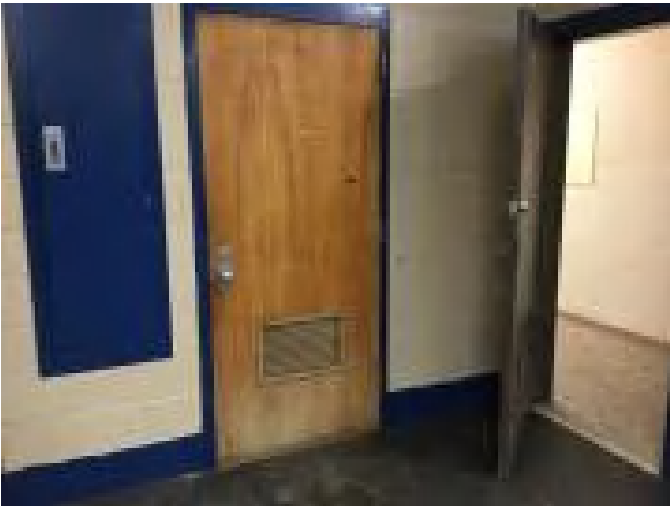
System: C1020 - Interior Doors

Location: Throughout Building
Distress: Beyond Service Life
Category: Deferred Maintenance
Priority: 3 - Necessary/Not Yet Critical (Years 2-5)
Correction: Renew System
Qty: 6,018.00
Unit of Measure: S.F.
Estimate: \$16,483.00
Assessor Name: Somnath Das
Date Created: 02/08/2017

Notes: The interior doors are beyond their service life and should be replaced.

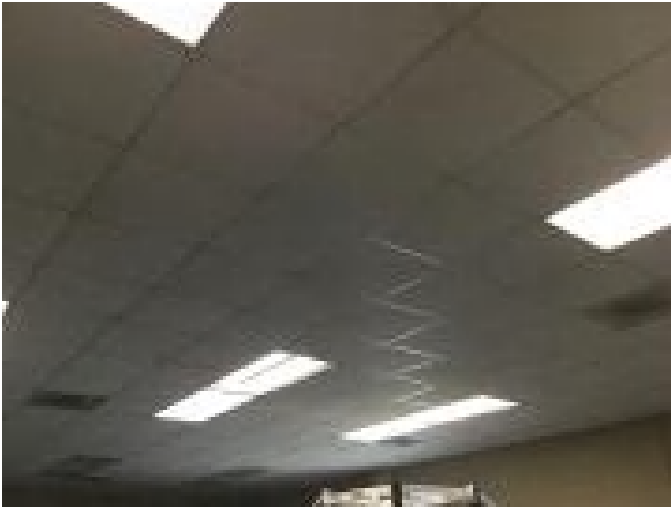
System: C3030 - Ceiling Finishes

Location: Throughout Building
Distress: Beyond Service Life
Category: Deferred Maintenance
Priority: 3 - Necessary/Not Yet Critical (Years 2-5)
Correction: Renew System
Qty: 6,018.00
Unit of Measure: S.F.
Estimate: \$71,295.00
Assessor Name: Somnath Das
Date Created: 02/08/2017

Notes: The ceiling finishes are beyond their service life and should be replaced.

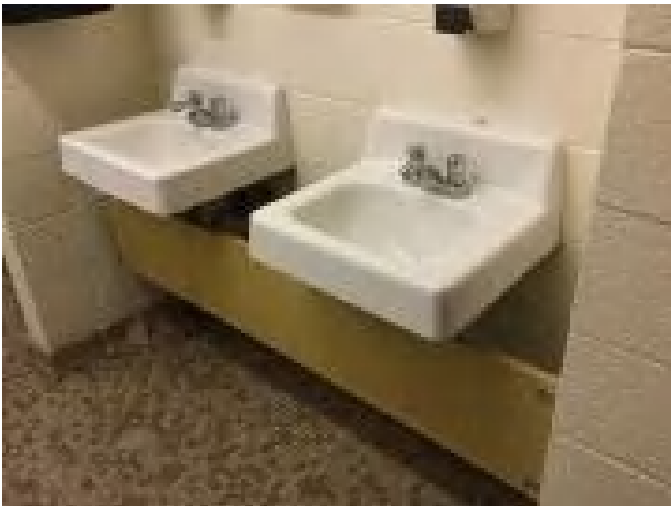
System: D2010 - Plumbing Fixtures

Location: Throughout Building
Distress: Beyond Service Life
Category: Deferred Maintenance
Priority: 3 - Necessary/Not Yet Critical (Years 2-5)
Correction: Renew System
Qty: 6,018.00
Unit of Measure: S.F.
Estimate: \$59,711.00
Assessor Name: Somnath Das
Date Created: 02/08/2017

Notes: The plumbing fixtures are beyond their service life and should be replaced.

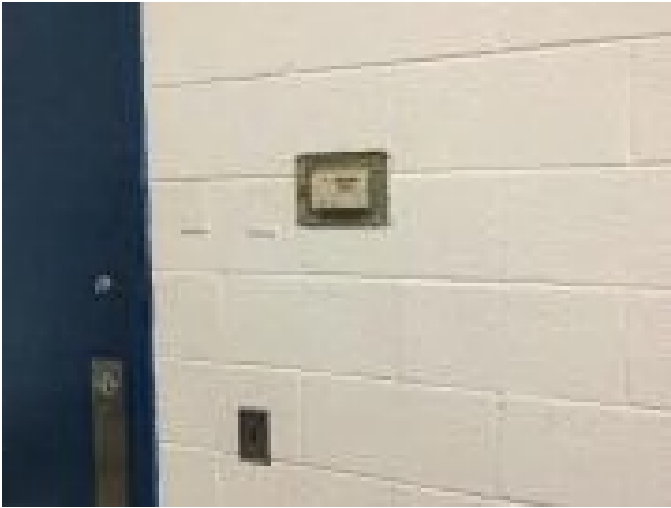
System: D3060 - Controls & Instrumentation

Location: Throughout Building
Distress: Beyond Service Life
Category: Deferred Maintenance
Priority: 3 - Necessary/Not Yet Critical (Years 2-5)
Correction: Renew System
Qty: 6,018.00
Unit of Measure: S.F.
Estimate: \$17,940.00
Assessor Name: Somnath Das
Date Created: 02/08/2017

Notes: The controls and instrumentation system is beyond its service life and should be replaced.

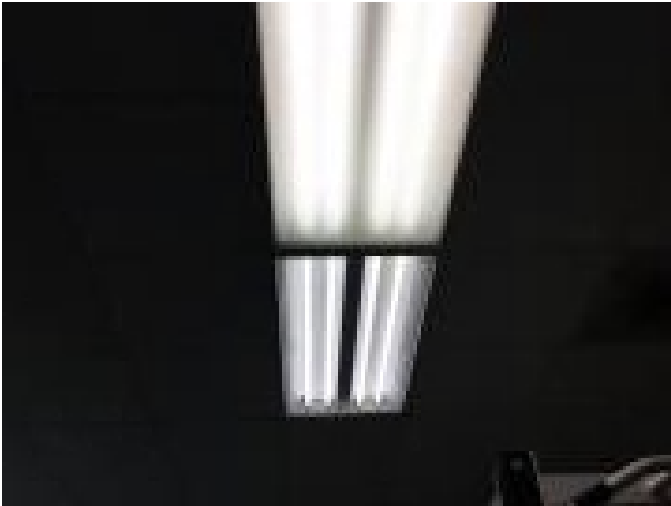
System: D5020 - Lighting

Location: Throughout Building
Distress: Beyond Service Life
Category: Deferred Maintenance
Priority: 3 - Necessary/Not Yet Critical (Years 2-5)
Correction: Renew System
Qty: 6,018.00
Unit of Measure: S.F.
Estimate: \$71,825.00
Assessor Name: Somnath Das
Date Created: 02/08/2017

Notes: The lighting system is beyond its service life and should be replaced.

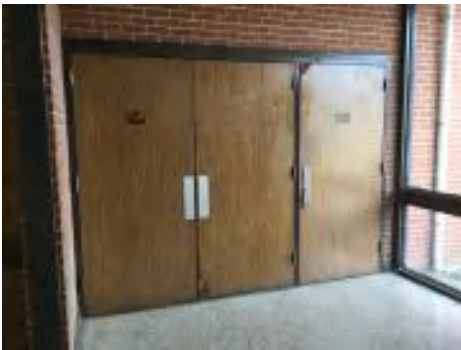
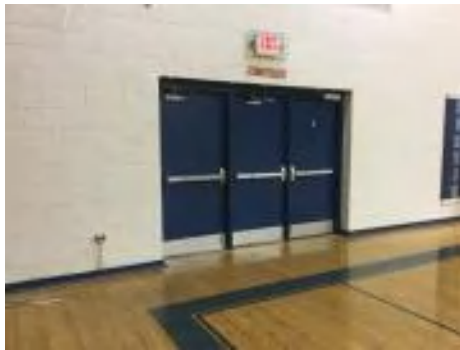
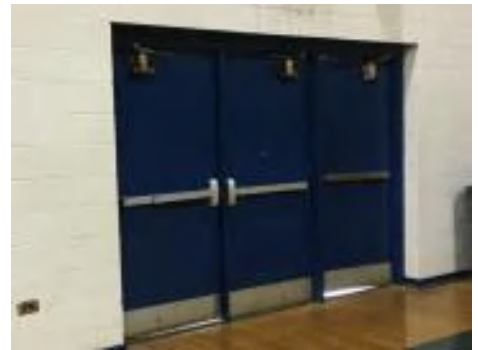
System: C1020 - Interior Doors

Note: The interior doors are beyond their service life and should be replaced.

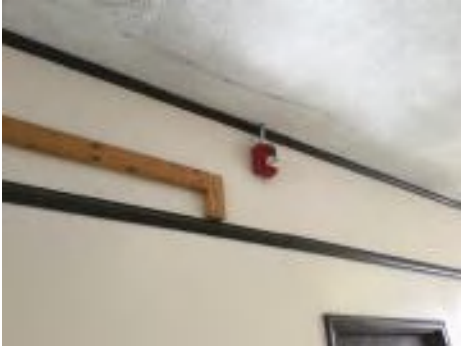
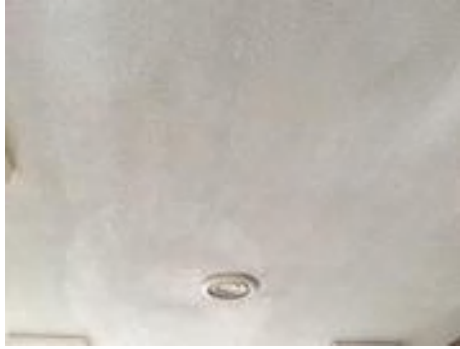
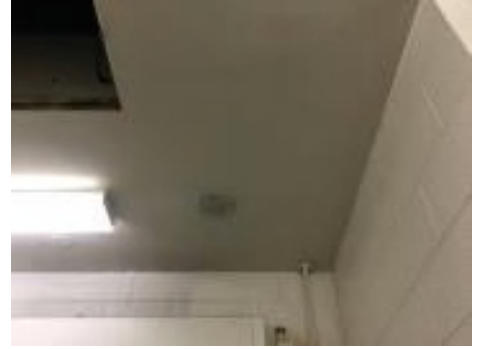
System: C3030 - Ceiling Finishes

Note: The ceiling finishes are beyond their service life and should be replaced.

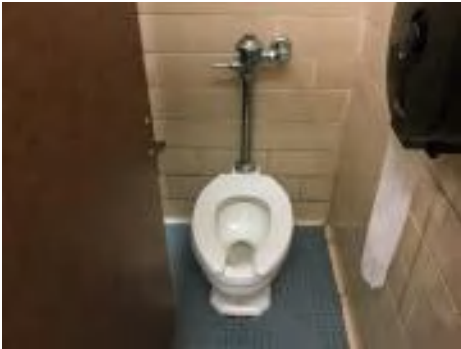
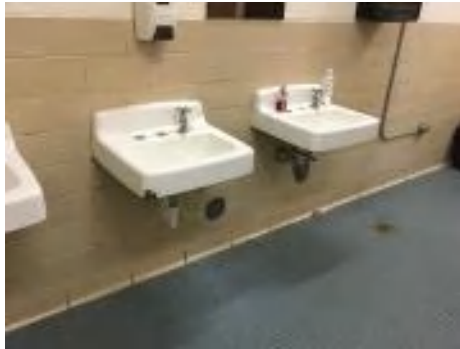
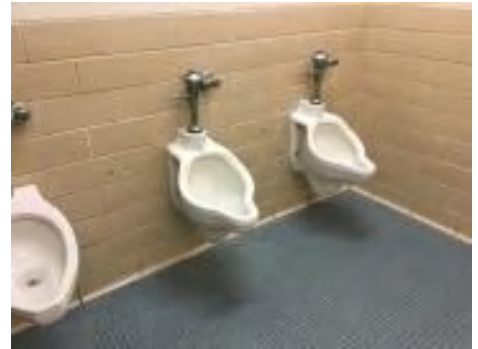
System: D2010 - Plumbing Fixtures

Note: The plumbing fixtures are beyond their service life and should be replaced.

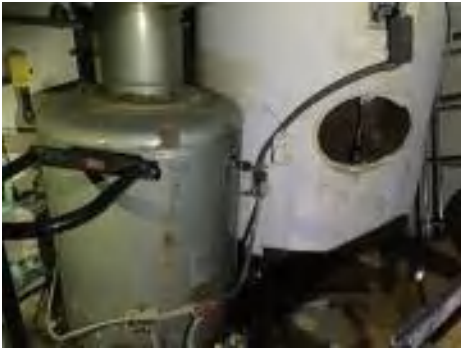
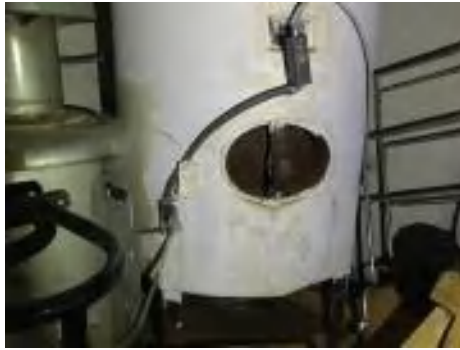
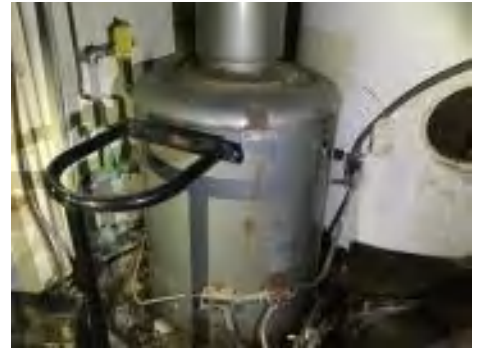
System: D2020 - Domestic Water Distribution

Note: The domestic water distribution system is beyond its service life and should be replaced.

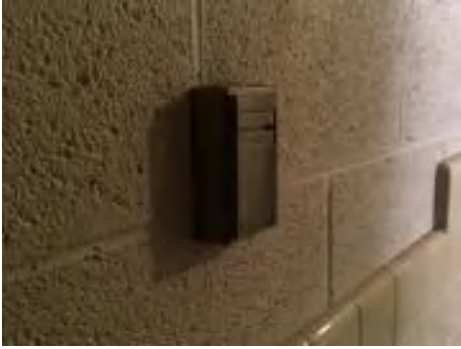
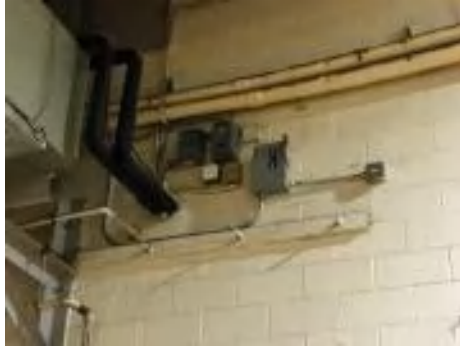
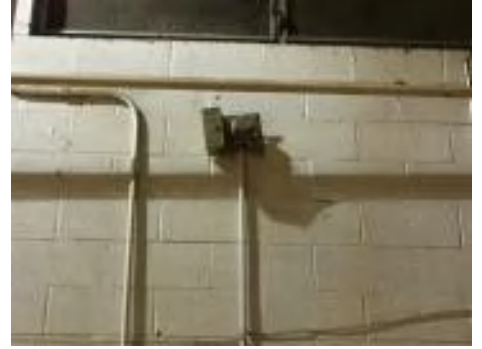
System: D3060 - Controls & Instrumentation

Note: The controls and instrumentation are beyond their service life and should be replaced.

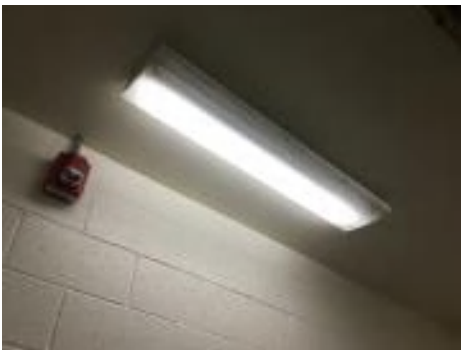
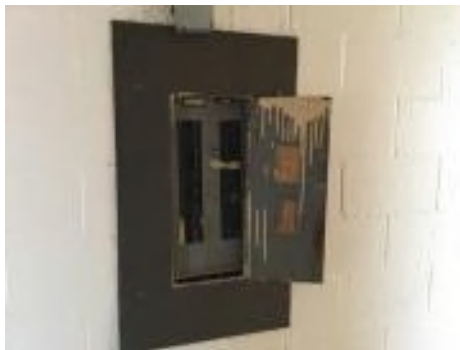
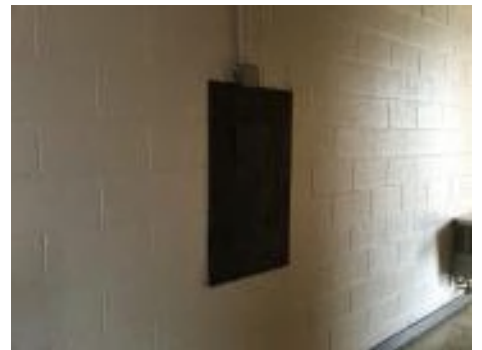
System: D5020 - Branch Wiring

Note: The branch wiring system is beyond its service life and should be replaced.

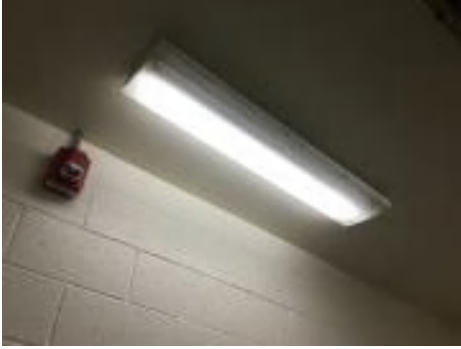
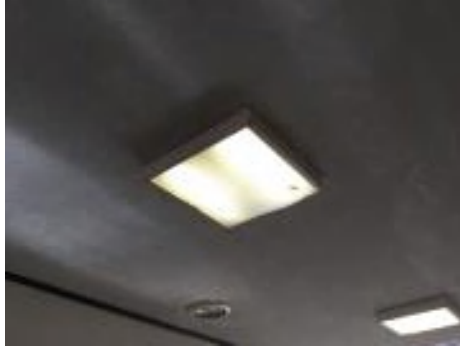
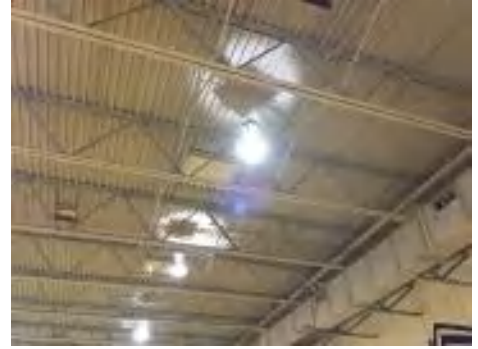
System: D5020 - Lighting

Note: The lighting system is beyond its service life and should be replaced.
