NC School District/080 Bertie County/Middle School

Bertie Middle

Campus Assessment Report

March 8, 2017

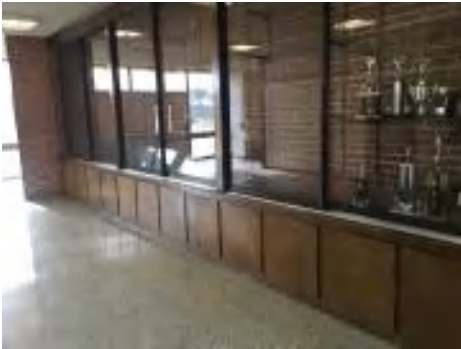
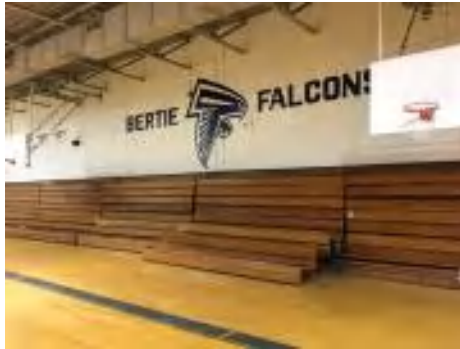
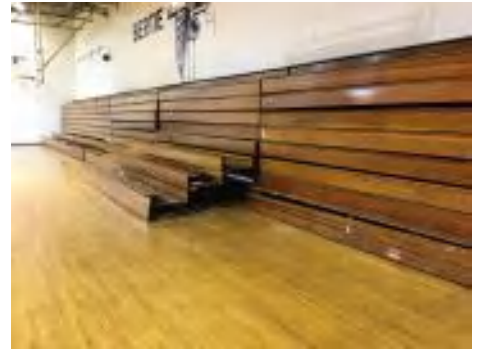
System: E2010 - Fixed Furnishings

Note: The fixed furnishings are beyond their service life and should be replaced.

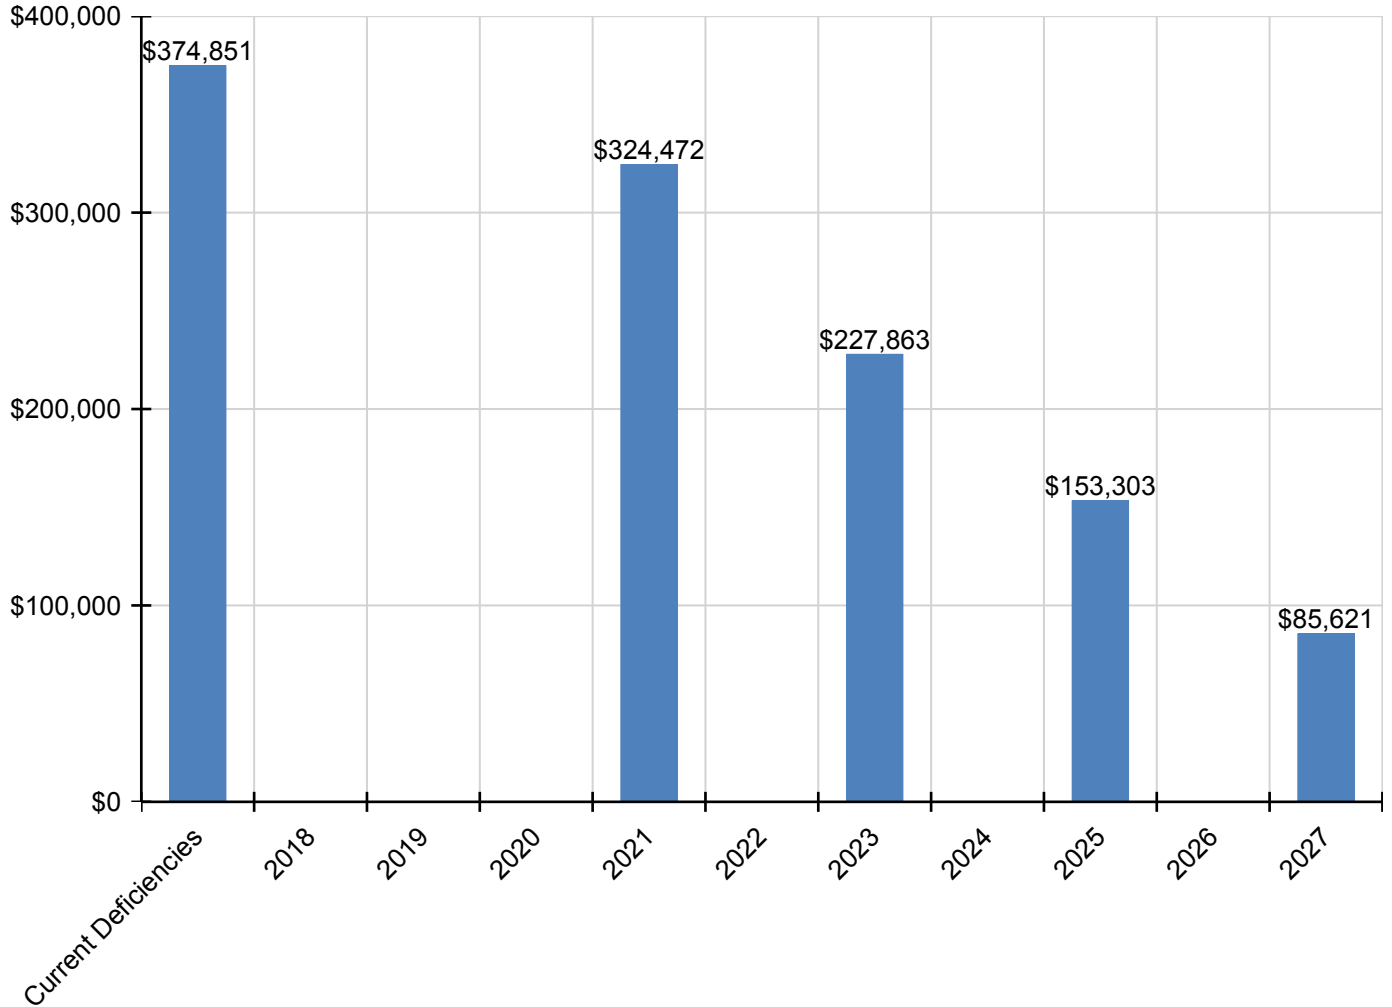
Forecasted Capital Renewal Requirement

The following chart shows the current building deficiencies and forecasting capital renewal or sustainment requirements over the next ten years.

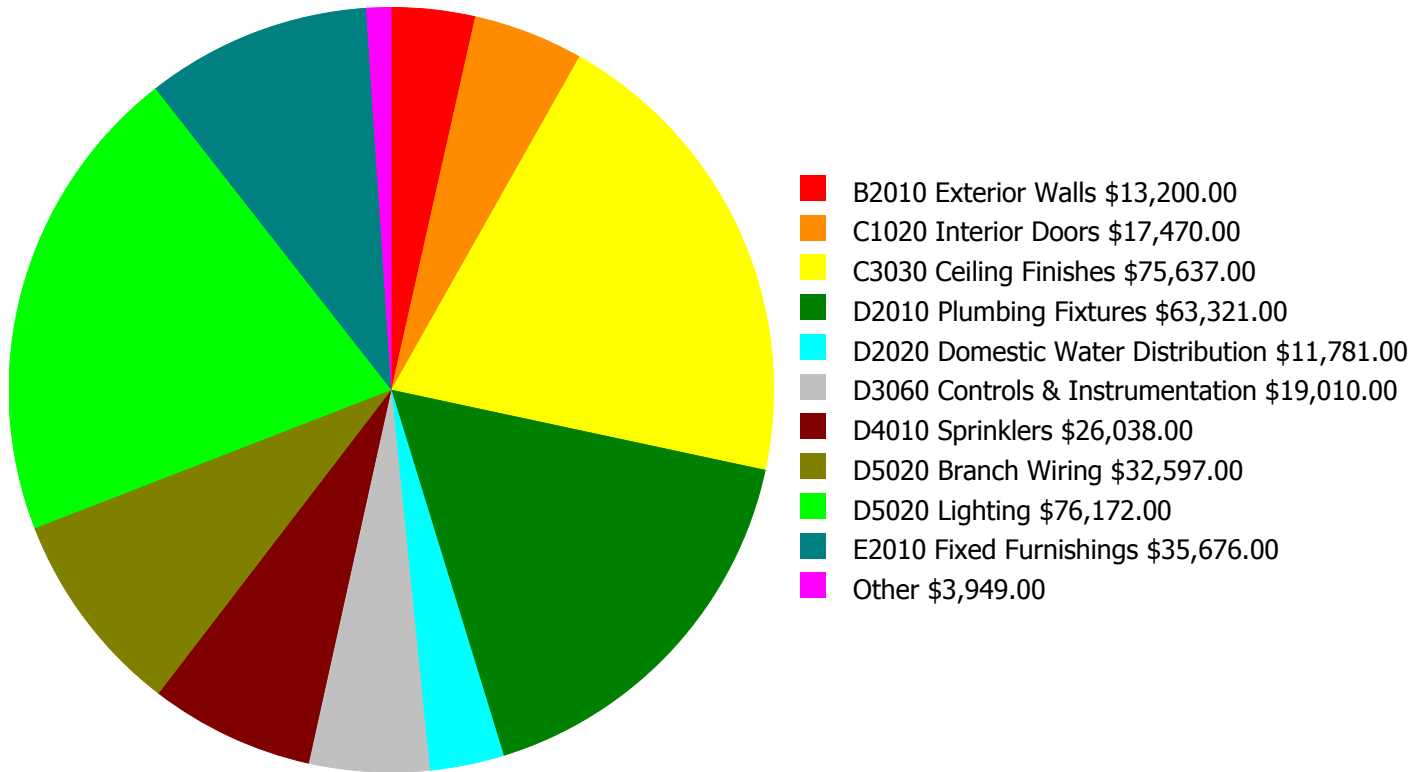
Deficiency Summary by System

Current deficiencies included assemblies that have reached or exceeded their design life or components of the assemblies that are in need of repair. Assemblies that have reached their design life are identified as current deficiencies and assigned the distress 'Beyond Useful Life'. The following chart lists all current deficiencies associated with this facility.

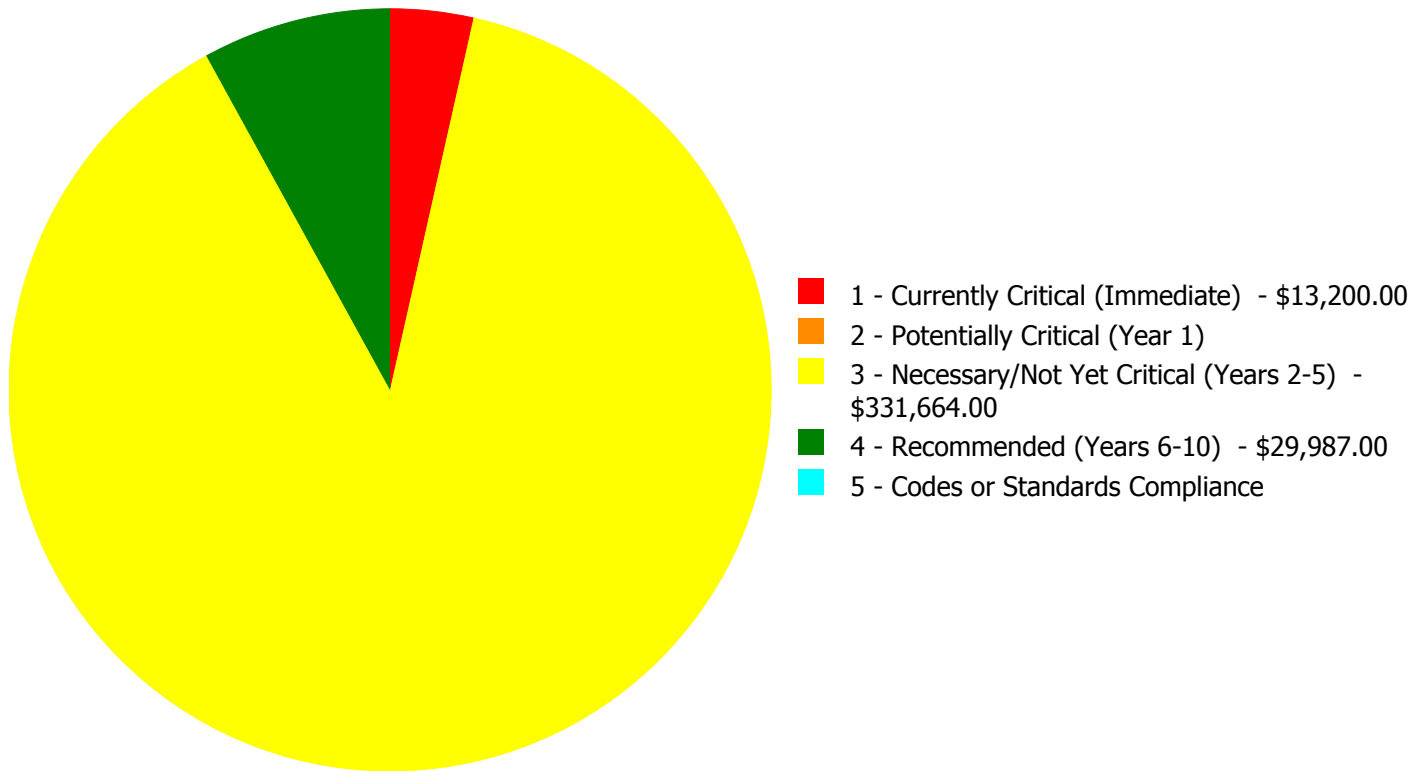
Deficiency Summary by Priority

The following chart shows the total repair costs broken down by priority. Assessors assigned deficiencies within eCOMET to one of the following priority categories:

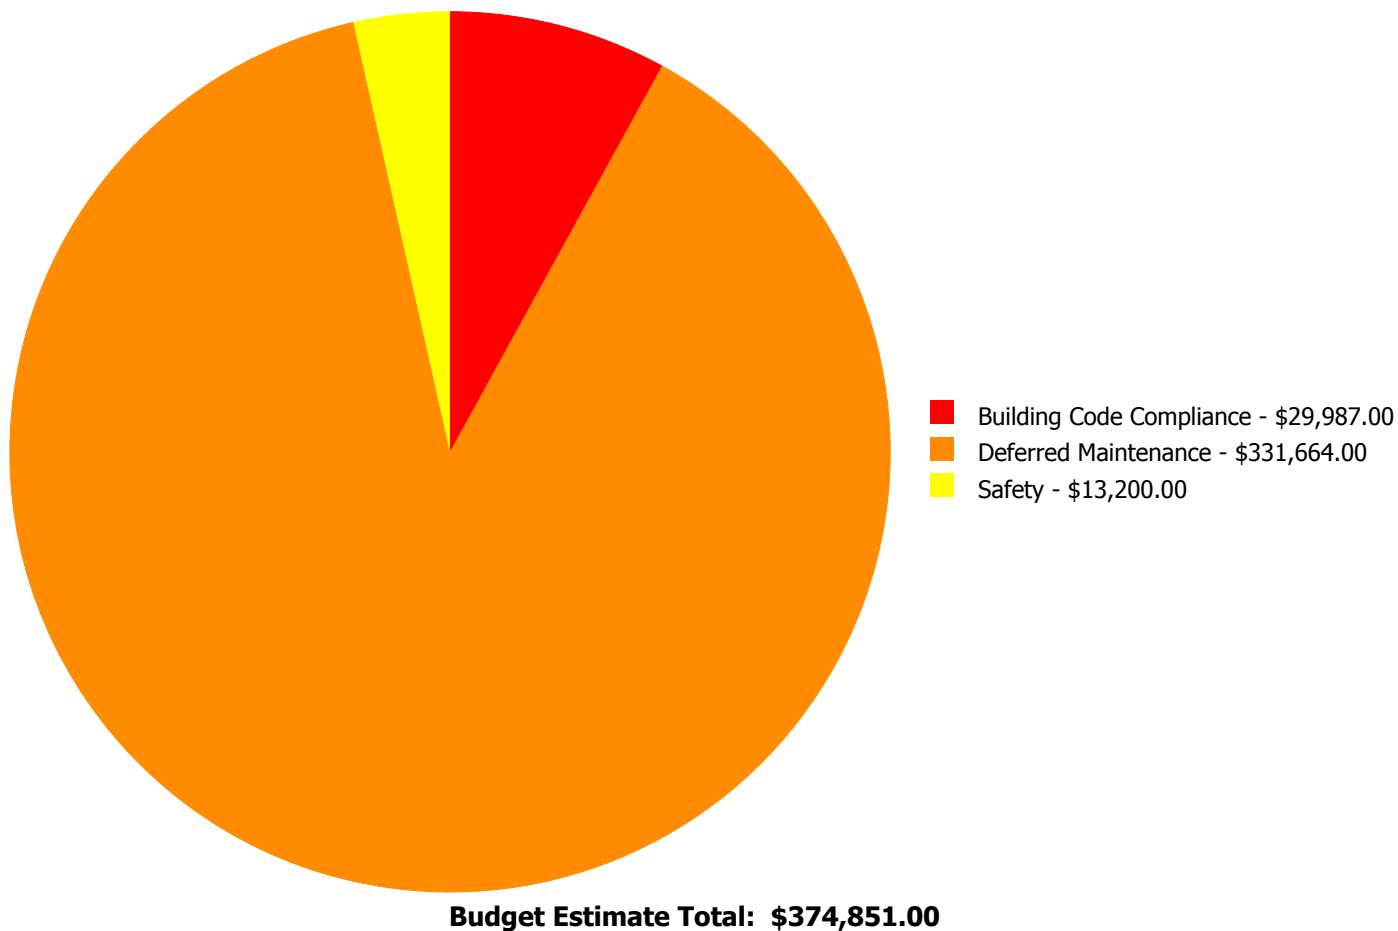
Deficiency Summary by Category

The following chart shows the total repair costs broken down by deficiency categories. Assessors assigned deficiencies to one of the following categories:

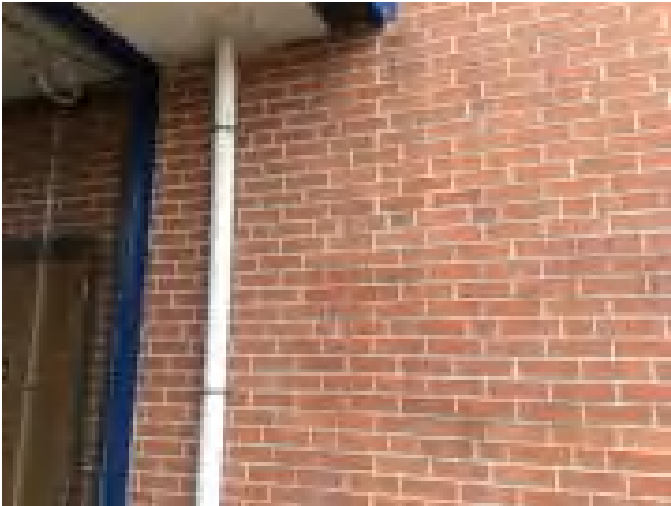
System: B2010 - Exterior Walls

Location: Exterior walls
Distress: Failing
Category: Safety
Priority: 1 - Currently Critical (Immediate)
Correction: Engineering Study-2016-11-15 17:41:59
Qty: 1.00
Unit of Measure: Ea.
Estimate: \$13,200.00
Assessor Name: Eduardo Lopez
Date Created: 02/02/2017

Notes: The exterior wall has visible cracks which should be studied by a professional engineer.

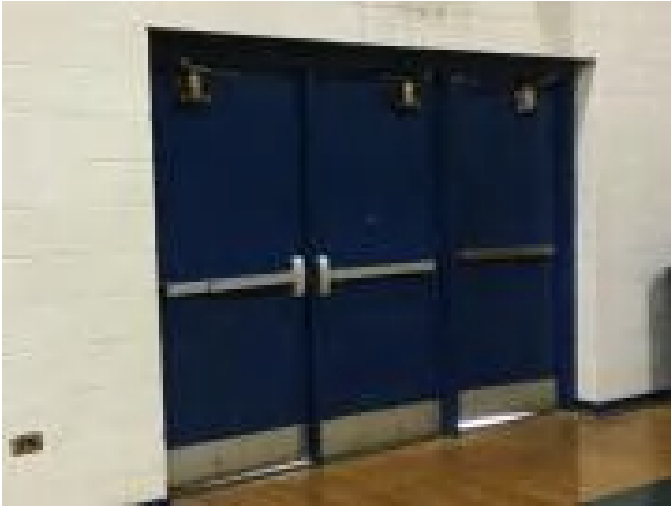
System: C1020 - Interior Doors

Location: Throughout Building
Distress: Beyond Service Life
Category: Deferred Maintenance
Priority: 3 - Necessary/Not Yet Critical (Years 2-5)
Correction: Renew System
Qty: 6,085.00
Unit of Measure: S.F.
Estimate: \$17,470.00
Assessor Name: Eduardo Lopez
Date Created: 02/08/2017

Notes: The interior doors are beyond their service life and should be replaced.

Note: The interior doors are beyond their service life and should be replaced.

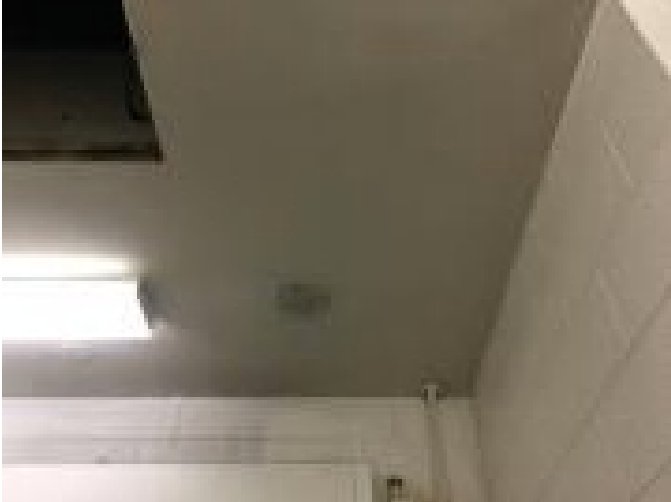
System: C3030 - Ceiling Finishes

Location: Throughout Building
Distress: Beyond Service Life
Category: Deferred Maintenance
Priority: 3 - Necessary/Not Yet Critical (Years 2-5)
Correction: Renew System
Qty: 6,085.00
Unit of Measure: S.F.
Estimate: \$75,637.00
Assessor Name: Eduardo Lopez
Date Created: 02/08/2017

Notes: The ceiling finishes are beyond their service life and should be replaced.

Note: The ceiling finishes are beyond their service life and should be replaced.

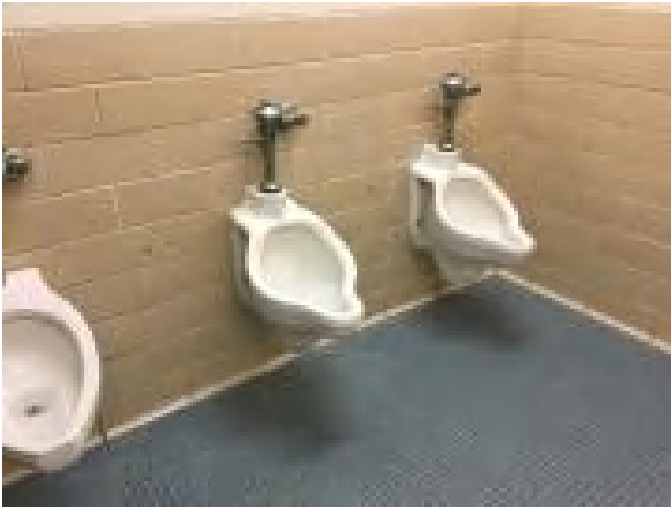
System: D2010 - Plumbing Fixtures

Location: Throughout Building
Distress: Beyond Service Life
Category: Deferred Maintenance
Priority: 3 - Necessary/Not Yet Critical (Years 2-5)
Correction: Renew System
Qty: 6,085.00
Unit of Measure: S.F.
Estimate: \$63,321.00
Assessor Name: Eduardo Lopez
Date Created: 02/08/2017

Notes: The plumbing fixtures are beyond their service life and should be replaced.

Note: The plumbing fixtures are beyond their service life and should be replaced.

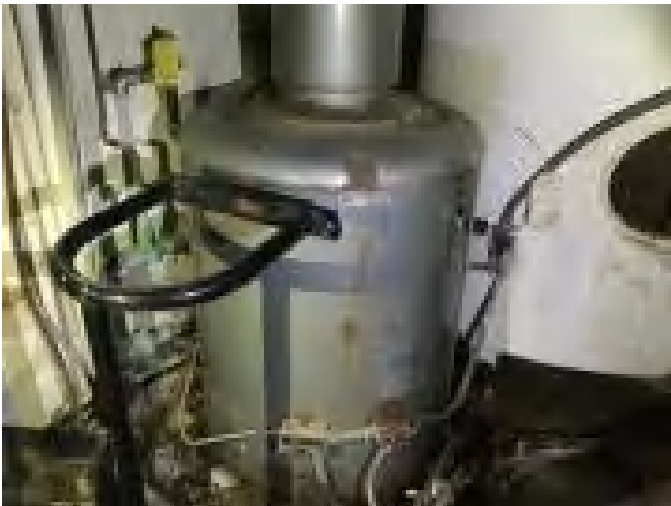
System: D2020 - Domestic Water Distribution

Location: Throughout Building
Distress: Beyond Service Life
Category: Deferred Maintenance
Priority: 3 - Necessary/Not Yet Critical (Years 2-5)
Correction: Renew System
Qty: 6,085.00
Unit of Measure: S.F.
Estimate: \$11,781.00
Assessor Name: Eduardo Lopez
Date Created: 02/08/2017

Notes: The domestic water distribution system is beyond its service life and should be replaced.

Note: The domestic water distribution system is beyond its service life and should be replaced.

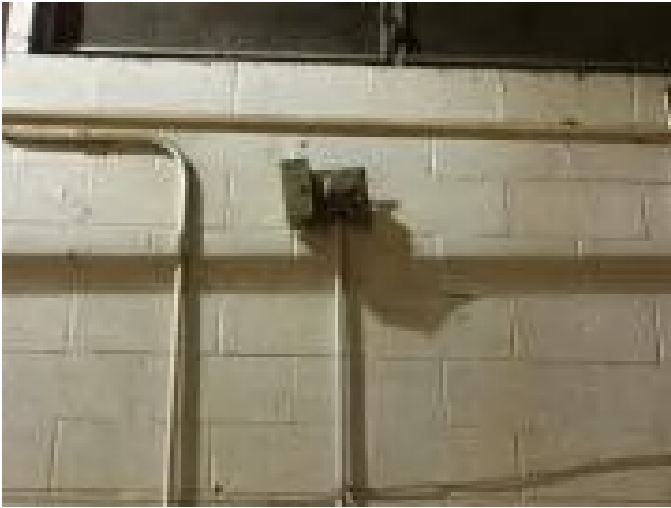
System: D3060 - Controls & Instrumentation

Location: Throughout Building
Distress: Beyond Service Life
Category: Deferred Maintenance
Priority: 3 - Necessary/Not Yet Critical (Years 2-5)
Correction: Renew System
Qty: 6,085.00
Unit of Measure: S.F.
Estimate: \$19,010.00
Assessor Name: Eduardo Lopez
Date Created: 02/08/2017

Notes: The controls and instrumentation are beyond their service life and should be replaced.

Note: The controls and instrumentation are beyond their service life and should be replaced.

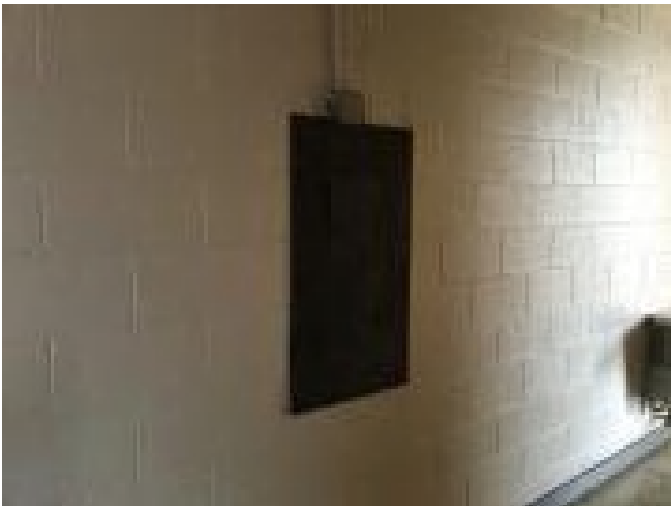
System: D5020 - Branch Wiring

Location: Throughout Building
Distress: Beyond Service Life
Category: Deferred Maintenance
Priority: 3 - Necessary/Not Yet Critical (Years 2-5)
Correction: Renew System
Qty: 6,085.00
Unit of Measure: S.F.
Estimate: \$32,597.00
Assessor Name: Eduardo Lopez
Date Created: 02/08/2017

Notes: The branch wiring system is beyond its service life and should be replaced.

Note: The branch wiring system is beyond its service life and should be replaced.

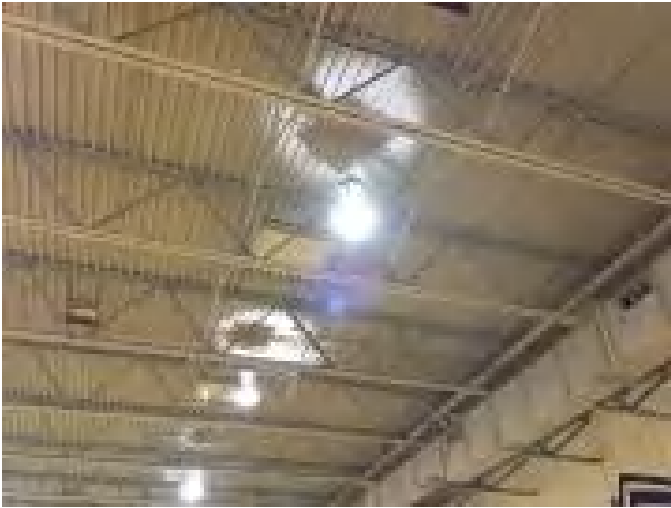
System: D5020 - Lighting

Location: Throughout Building
Distress: Beyond Service Life
Category: Deferred Maintenance
Priority: 3 - Necessary/Not Yet Critical (Years 2-5)
Correction: Renew System
Qty: 6,085.00
Unit of Measure: S.F.
Estimate: \$76,172.00
Assessor Name: Eduardo Lopez
Date Created: 02/08/2017

Notes: The lighting system is beyond its service life and should be replaced.

Note: The lighting system is beyond its service life and should be replaced.

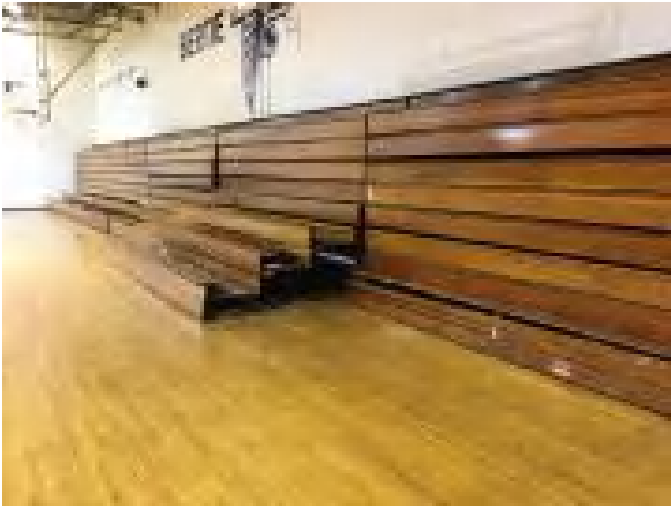
System: E2010 - Fixed Furnishings

Location: Throughout Building
Distress: Beyond Service Life
Category: Deferred Maintenance
Priority: 3 - Necessary/Not Yet Critical (Years 2-5)
Correction: Renew System
Qty: 6,085.00
Unit of Measure: S.F.
Estimate: \$35,676.00
Assessor Name: Eduardo Lopez
Date Created: 02/08/2017

Notes: The fixed furnishings are beyond their service life and should be replaced.

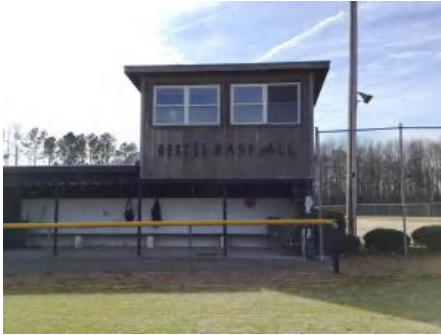
1). East Elevation - Feb 08, 2017

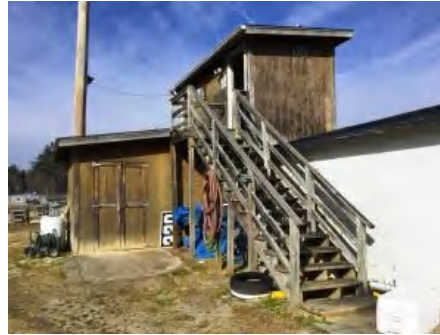
2). South Elevation - Feb 08, 2017

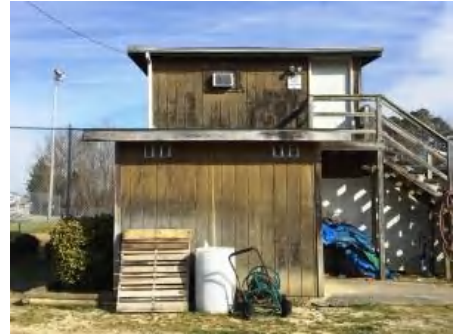
3). West Elevation - Feb 08, 2017

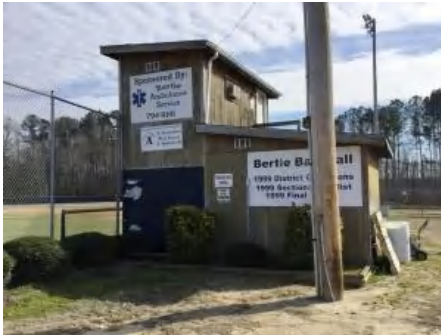
4). North Elevation - Feb 08, 2017

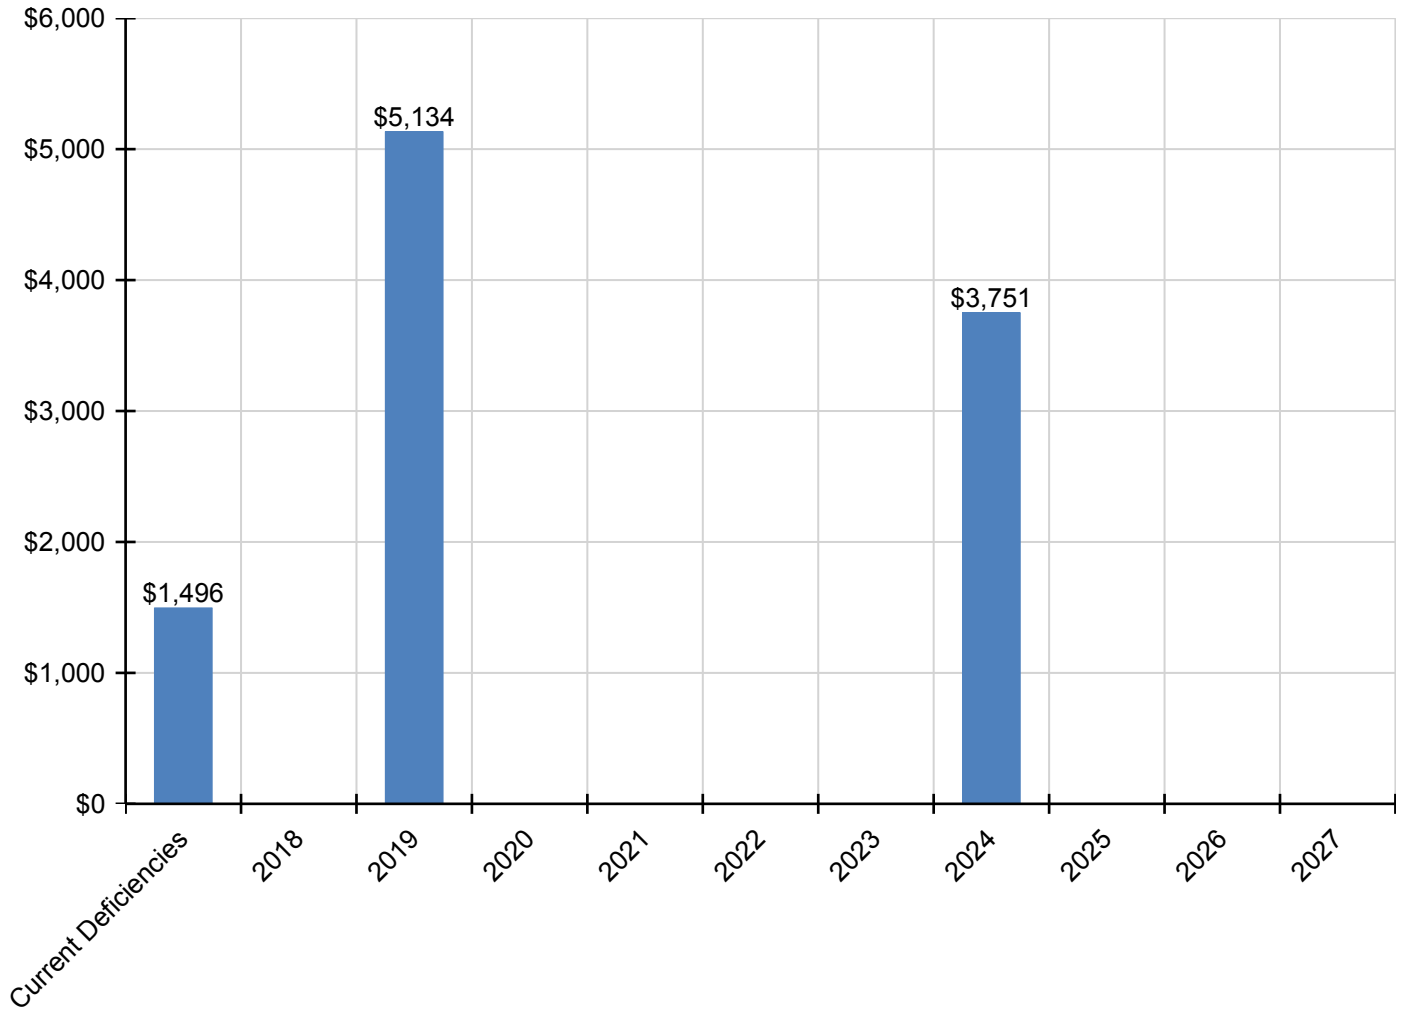
Forecasted Capital Renewal Requirement

The following chart shows the current building deficiencies and forecasting capital renewal or sustainment requirements over the next ten years.

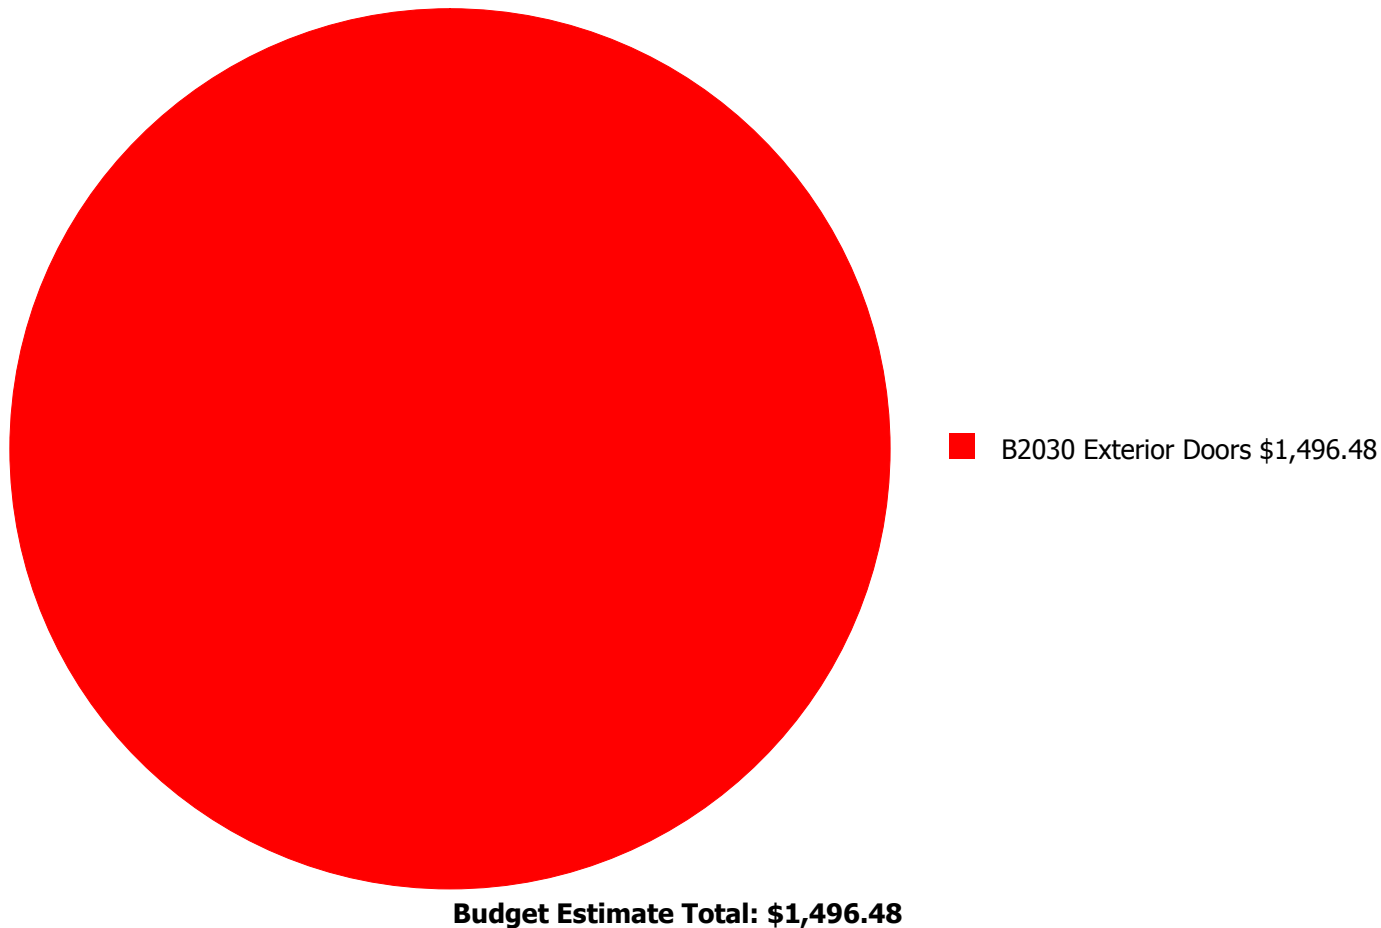
Deficiency Summary by System

Current deficiencies included assemblies that have reached or exceeded their design life or components of the assemblies that are in need of repair. Assemblies that have reached their design life are identified as current deficiencies and assigned the distress 'Beyond Useful Life'. The following chart lists all current deficiencies associated with this facility.

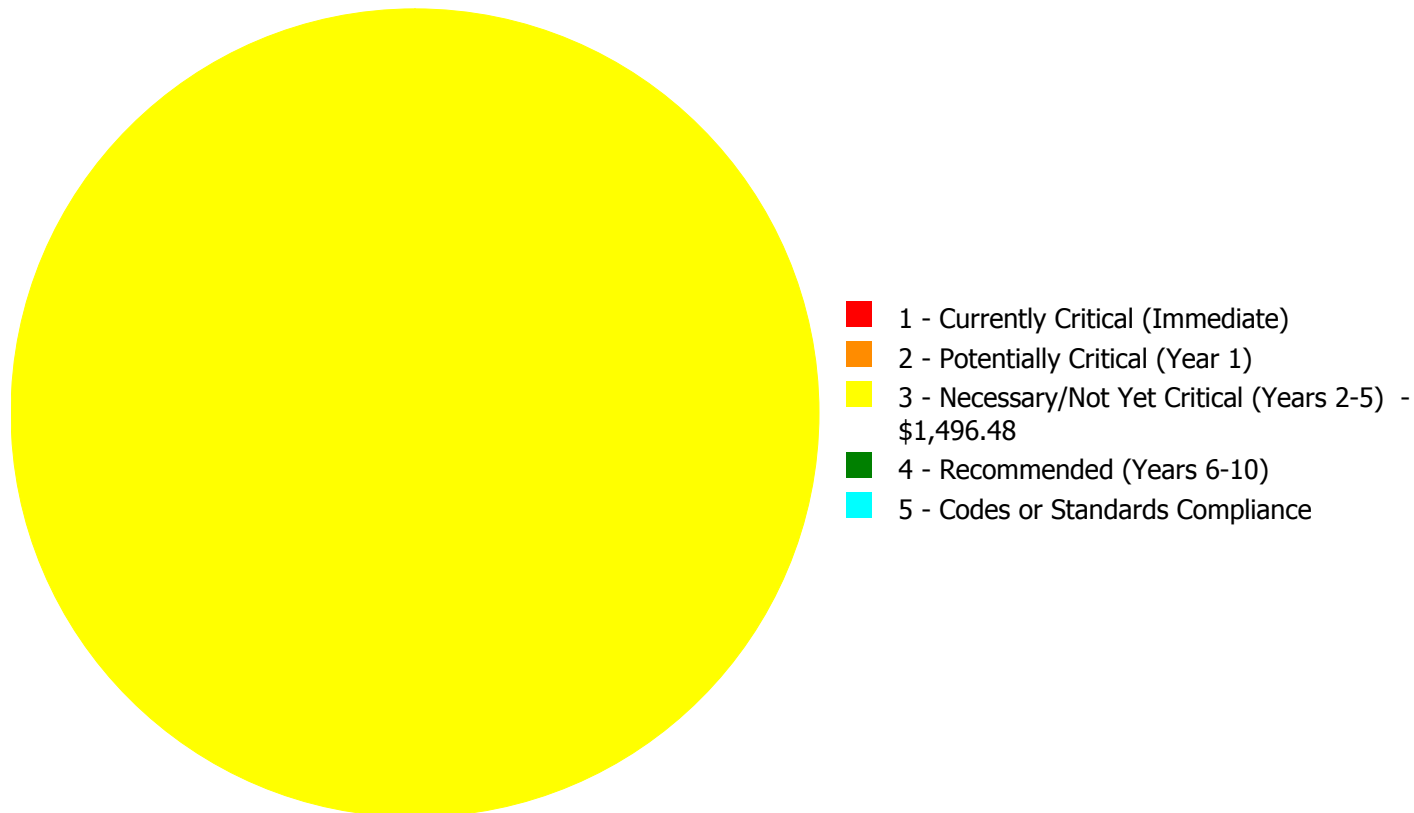
Deficiency Summary by Priority

The following chart shows the total repair costs broken down by priority. Assessors assigned deficiencies within eCOMET to one of the following priority categories:

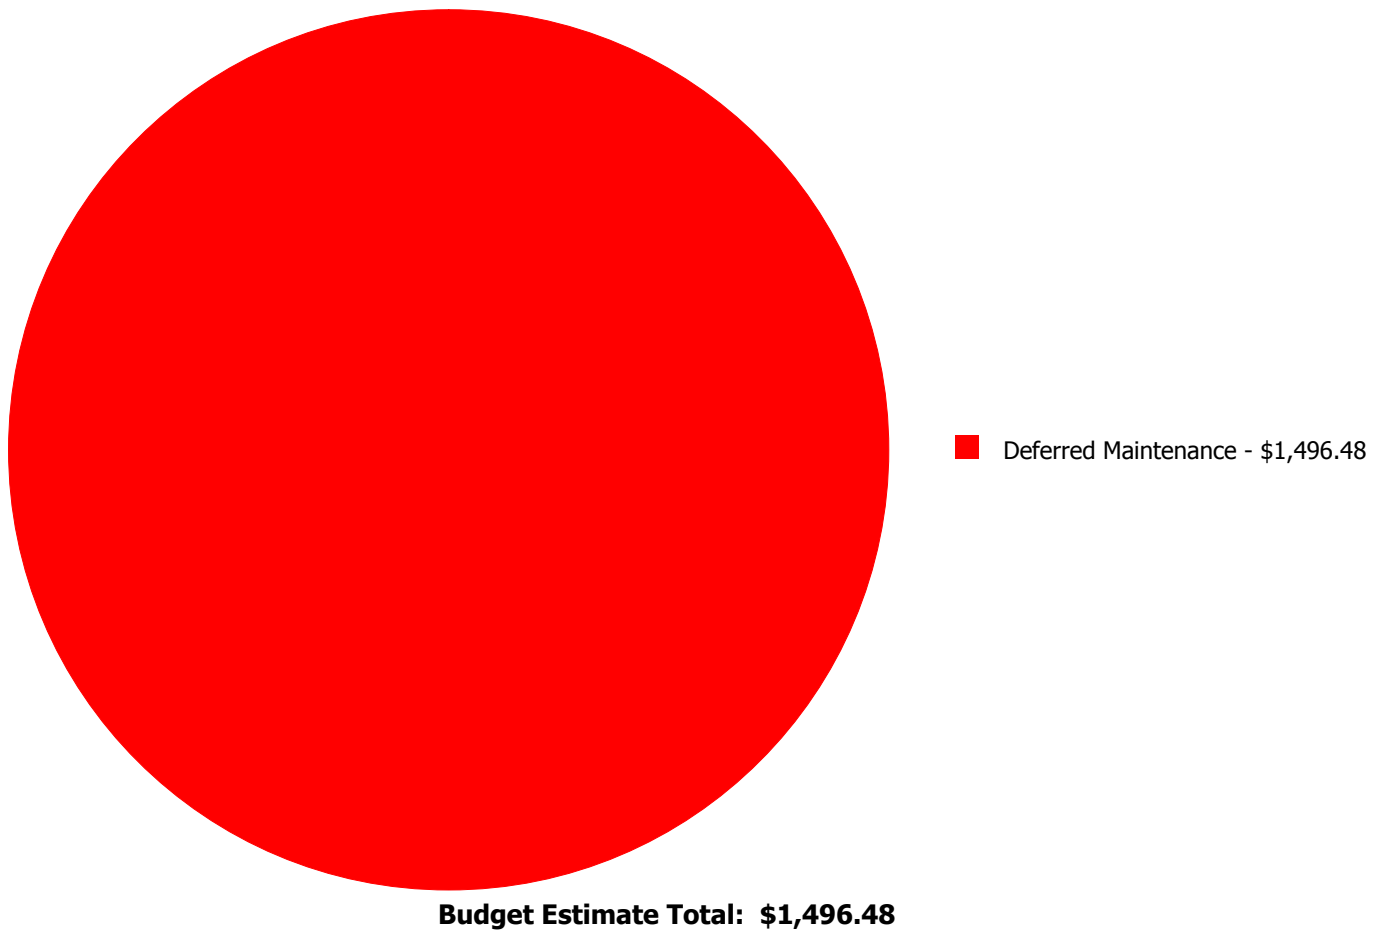
Deficiency Summary by Category

The following chart shows the total repair costs broken down by deficiency categories. Assessors assigned deficiencies to one of the following categories:

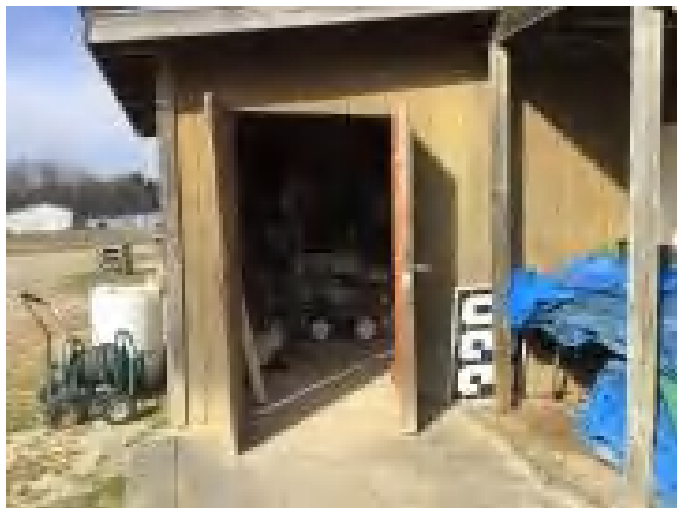
System: B2030 - Exterior Doors

Location: Exterior walls

Distress: Failing

Correction: Replace 3'-0" x 7'-0" wood louvered door

Notes: The exterior doors are in poor condition and should be replaced.

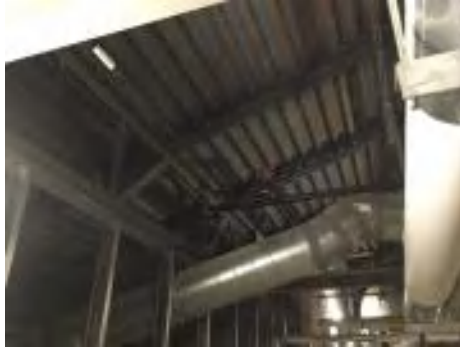
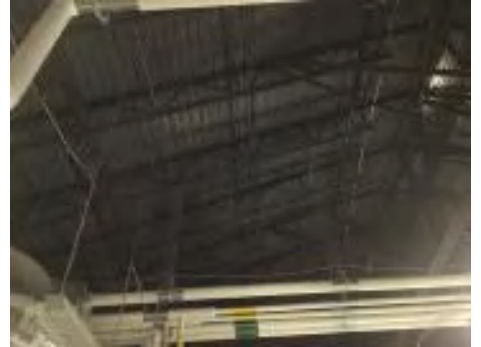
System: B1020 - Roof Construction

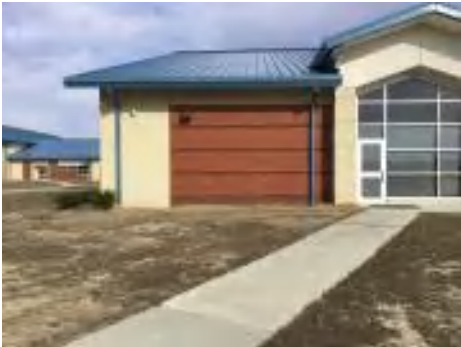
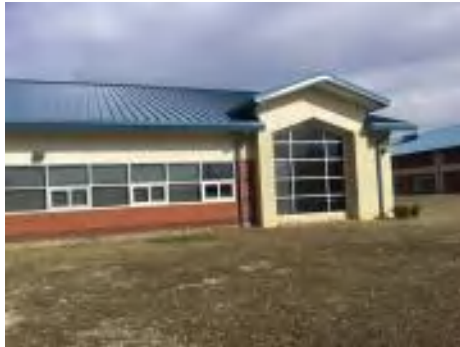
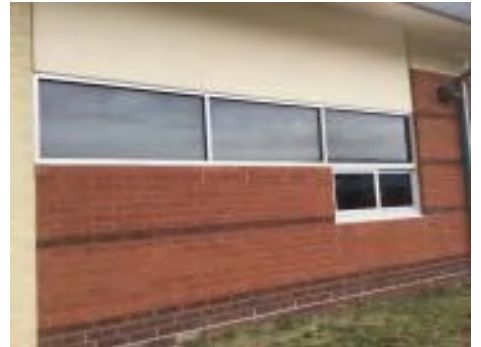
System: B2010 - Exterior Walls

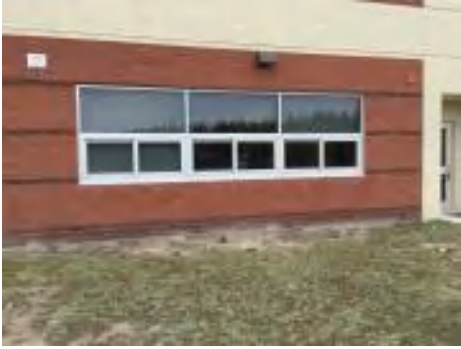
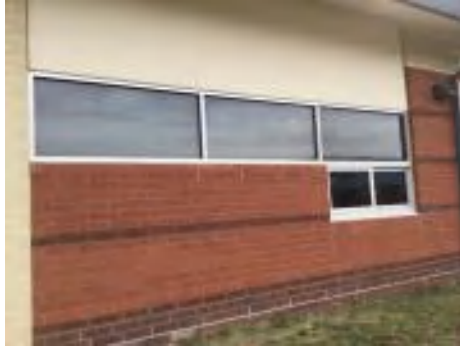
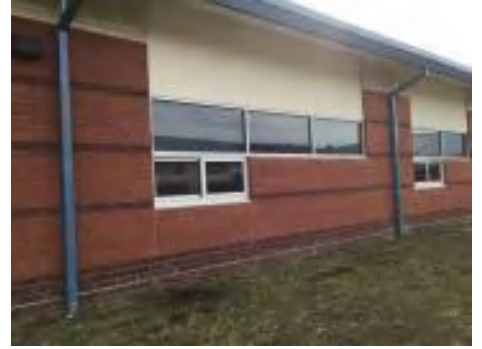
System: B2020 - Exterior Windows

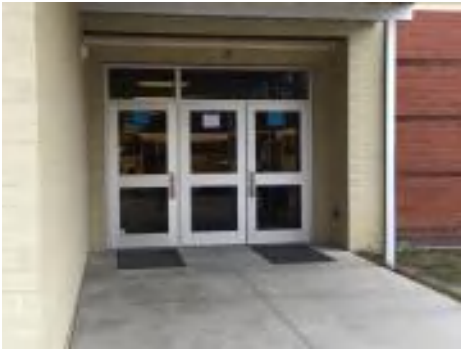
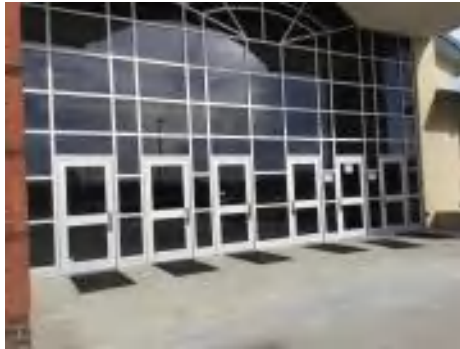
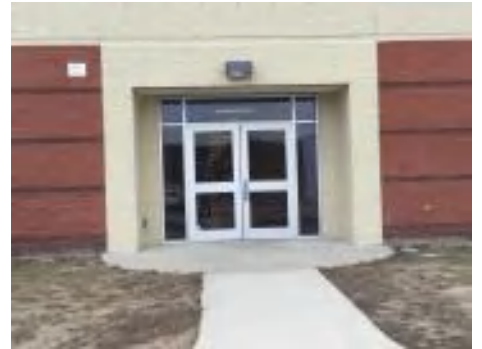
System: B2030 - Exterior Doors

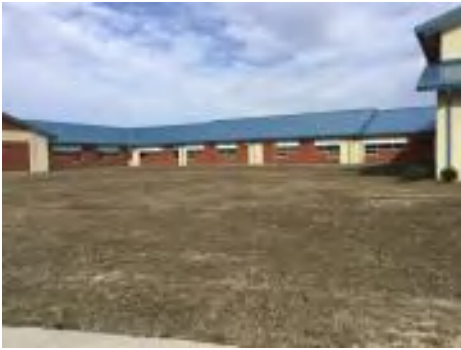
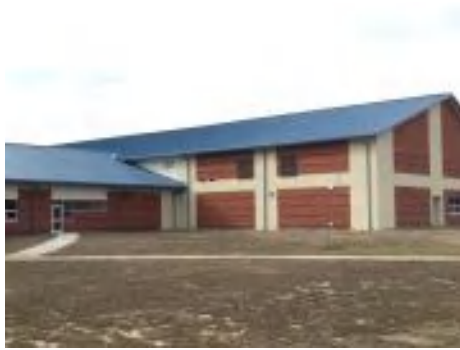
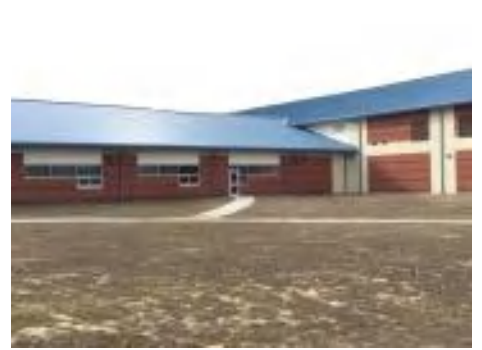
System: B3010130 - Preformed Metal Roofing

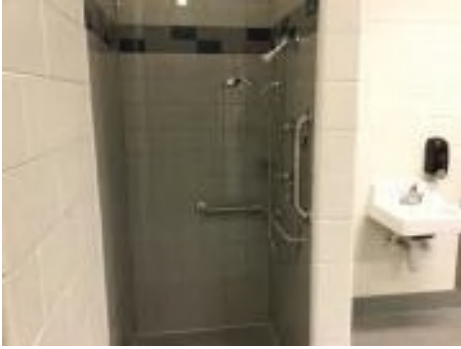
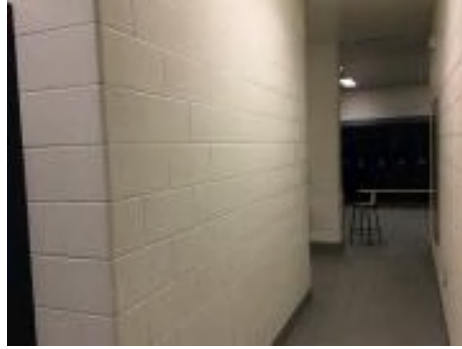
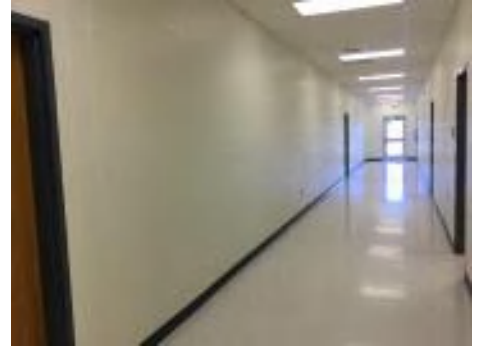
System: C1010 - Partitions

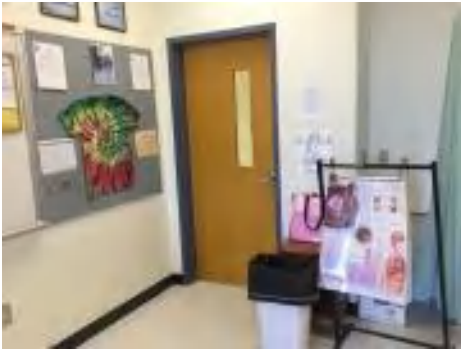
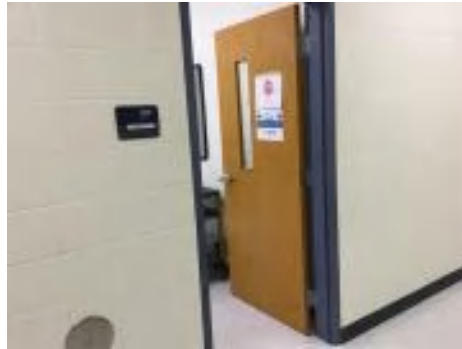
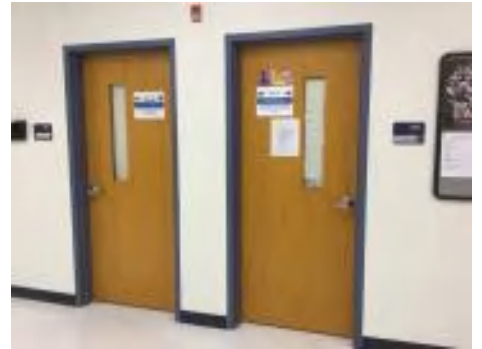
System: C1020 - Interior Doors

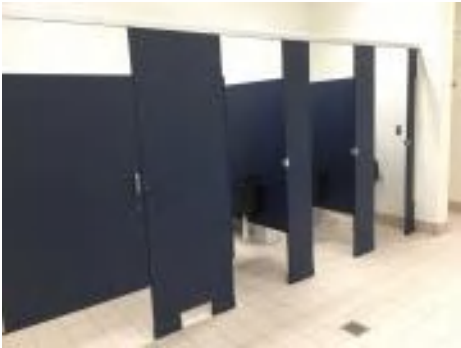
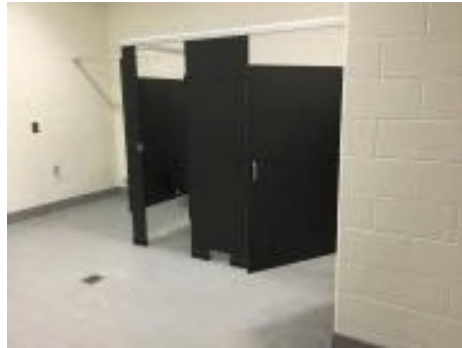
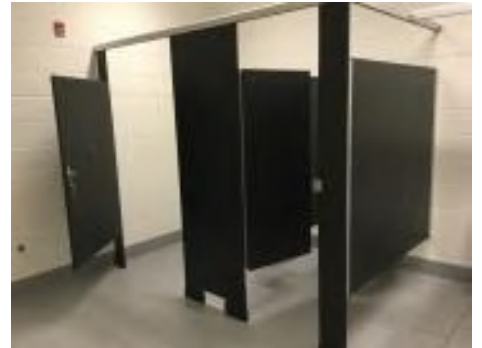
System: C1030 - Fittings

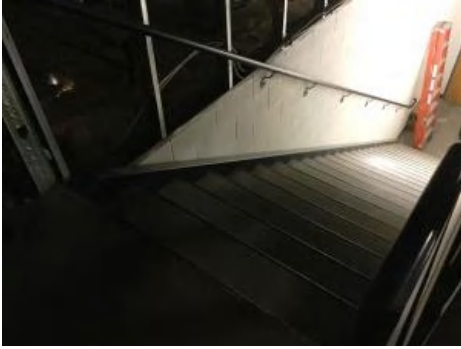
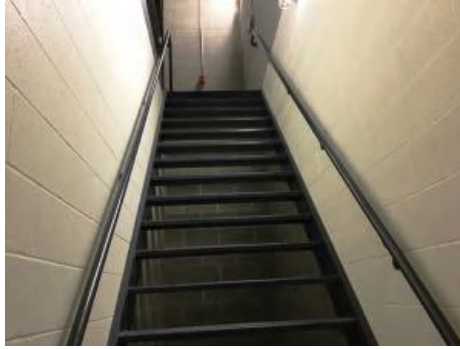
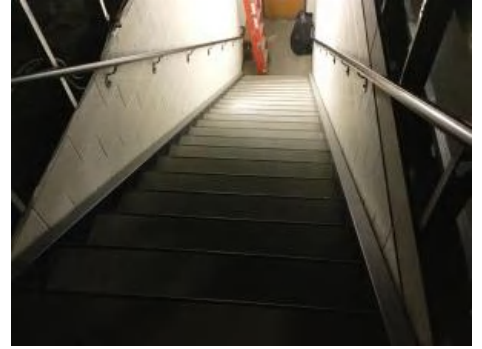
System: C2010 - Stair Construction

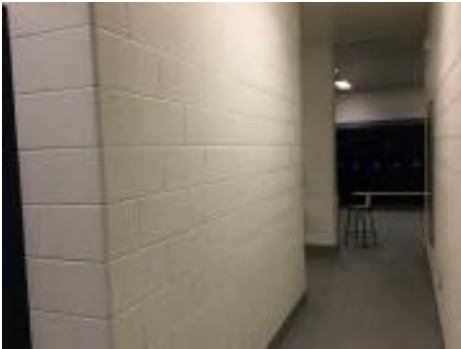
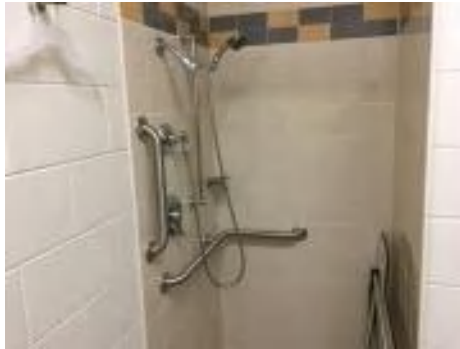
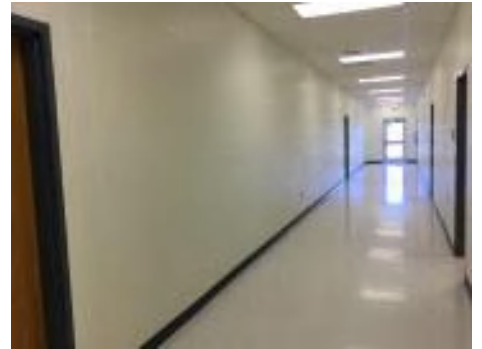
System: C3010 - Wall Finishes

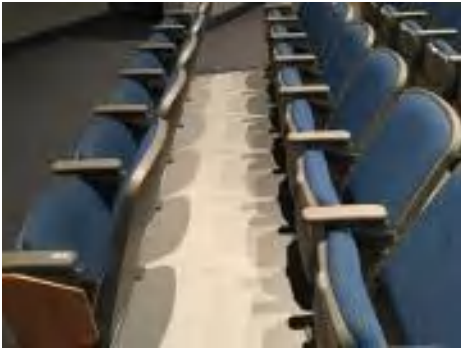
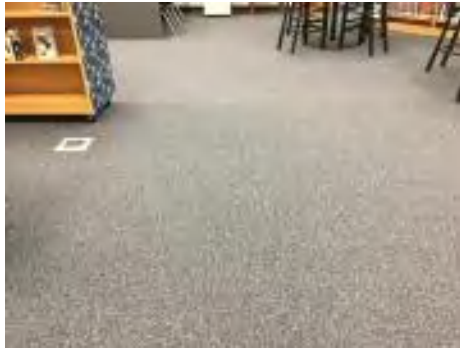
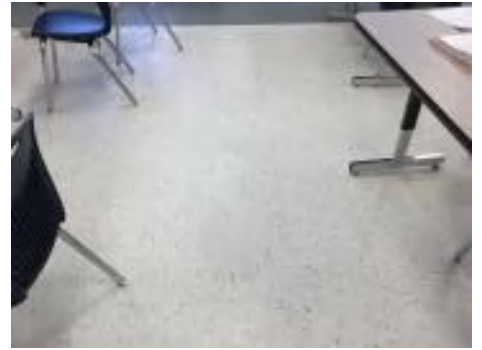
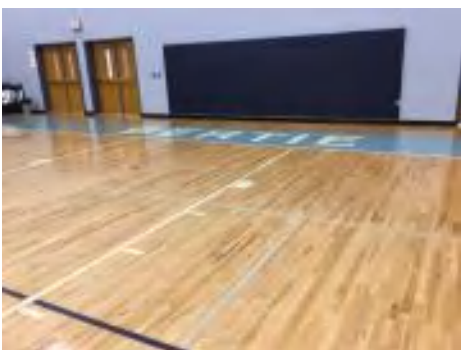
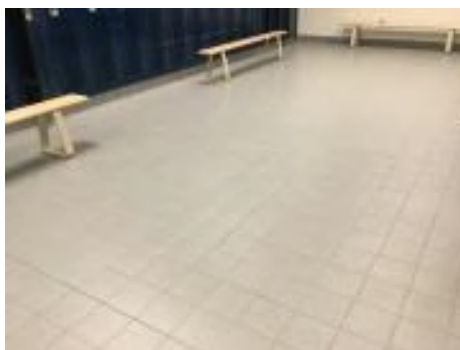
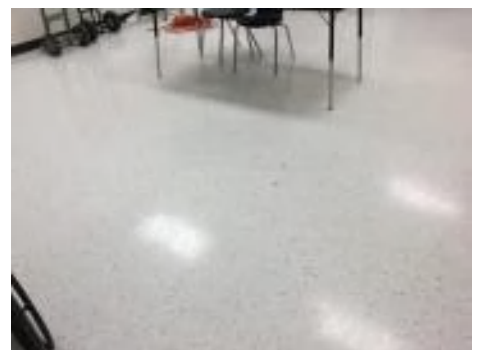
System: C3020 - Floor Finishes

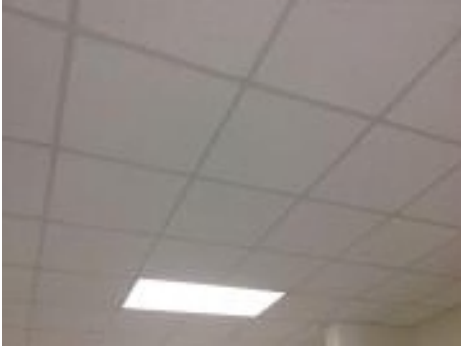
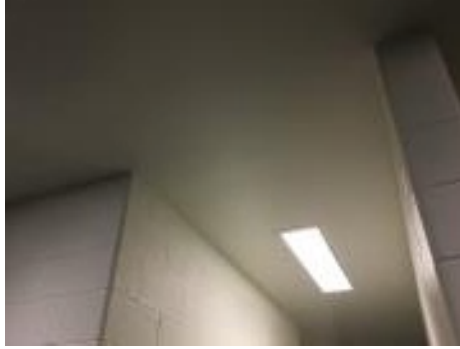
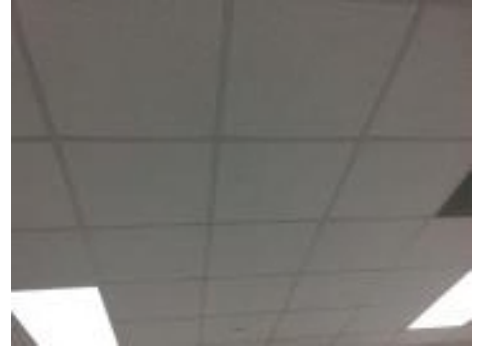
System: C3030 - Ceiling Finishes
