NC School District/080 Bertie County/Middle School

Bertie Middle

Campus Assessment Report

March 8, 2017

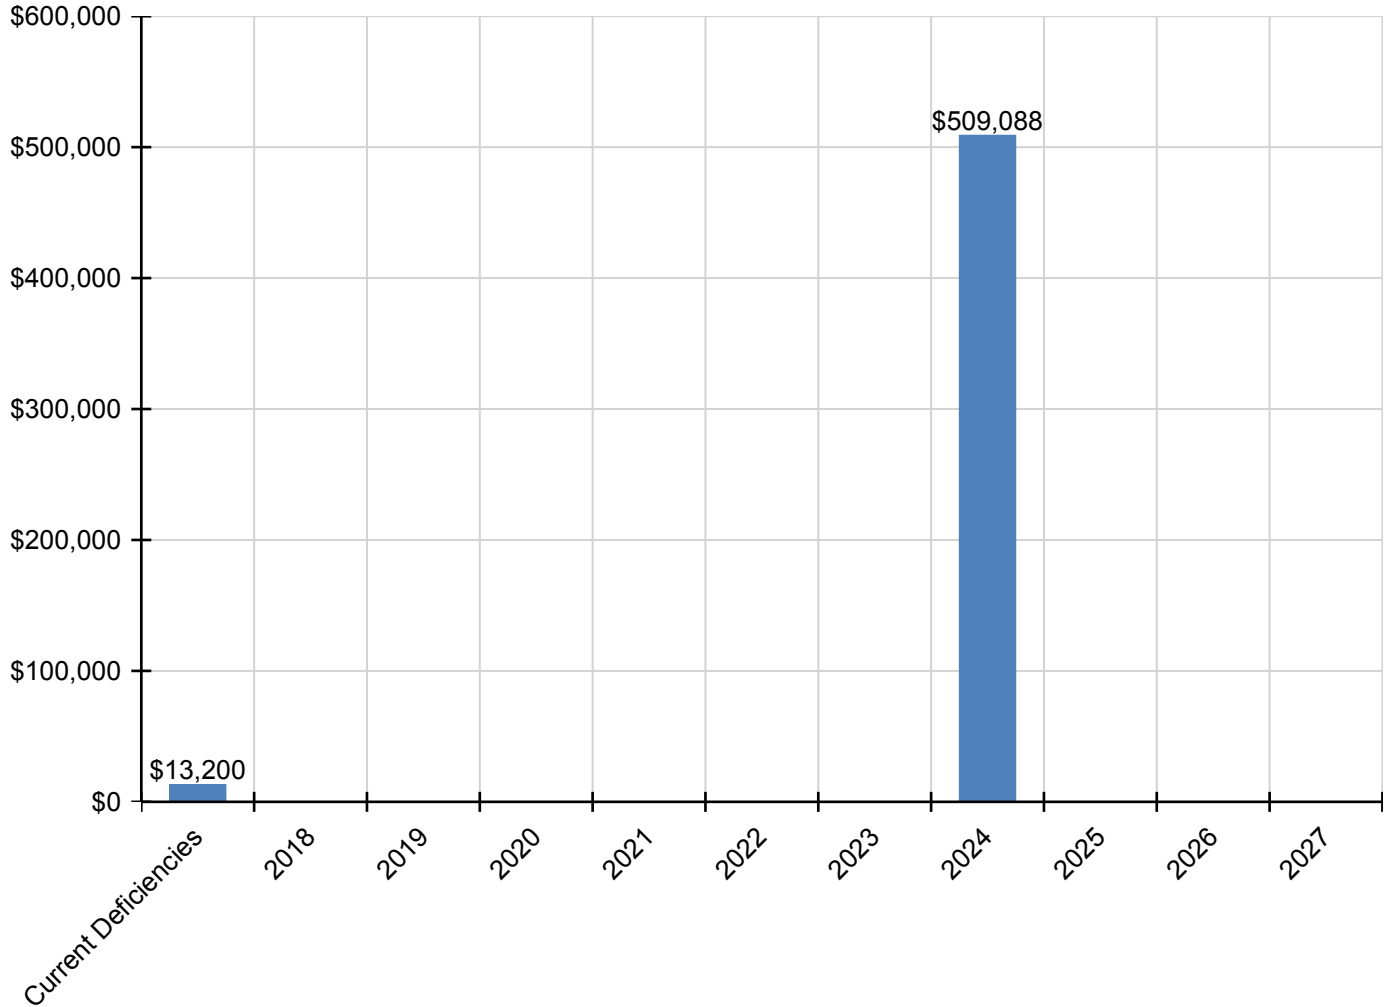
Forecasted Capital Renewal Requirement

The following chart shows the current building deficiencies and forecasting capital renewal or sustainment requirements over the next ten years.

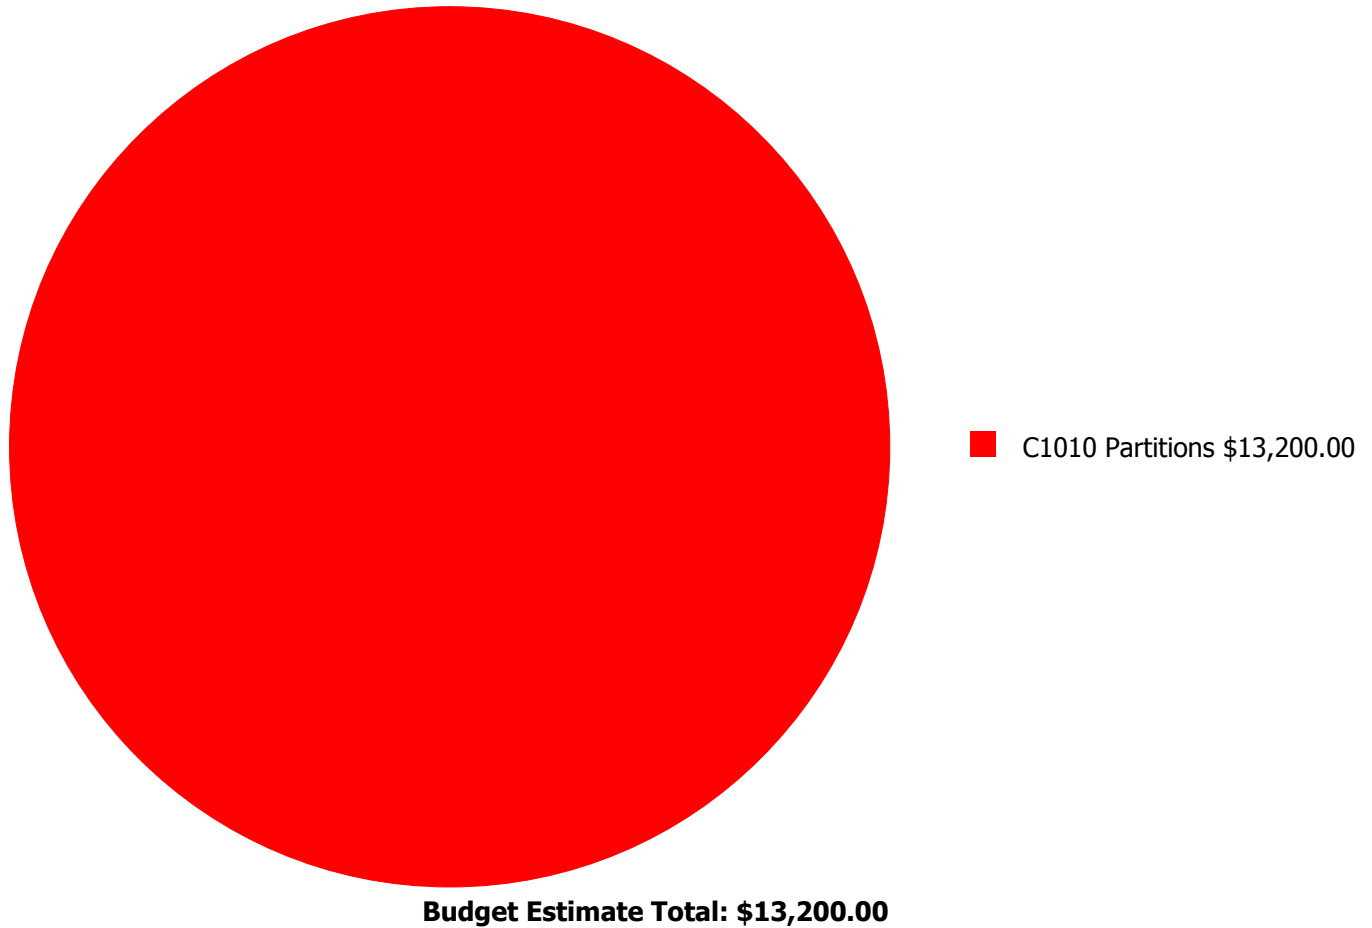
Deficiency Summary by System

Current deficiencies included assemblies that have reached or exceeded their design life or components of the assemblies that are in need of repair. Assemblies that have reached their design life are identified as current deficiencies and assigned the distress 'Beyond Useful Life'. The following chart lists all current deficiencies associated with this facility.

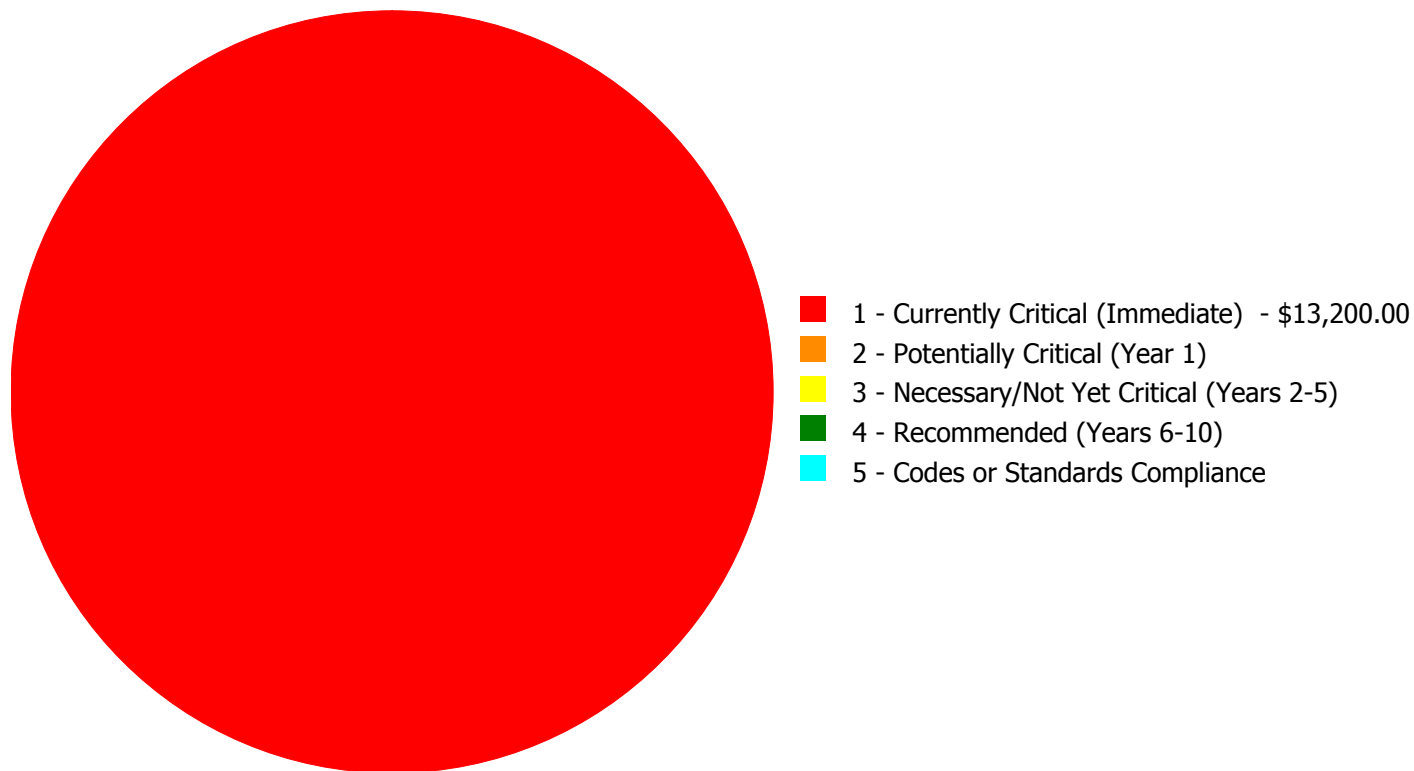
Deficiency Summary by Priority

The following chart shows the total repair costs broken down by priority. Assessors assigned deficiencies within eCOMET to one of the following priority categories:

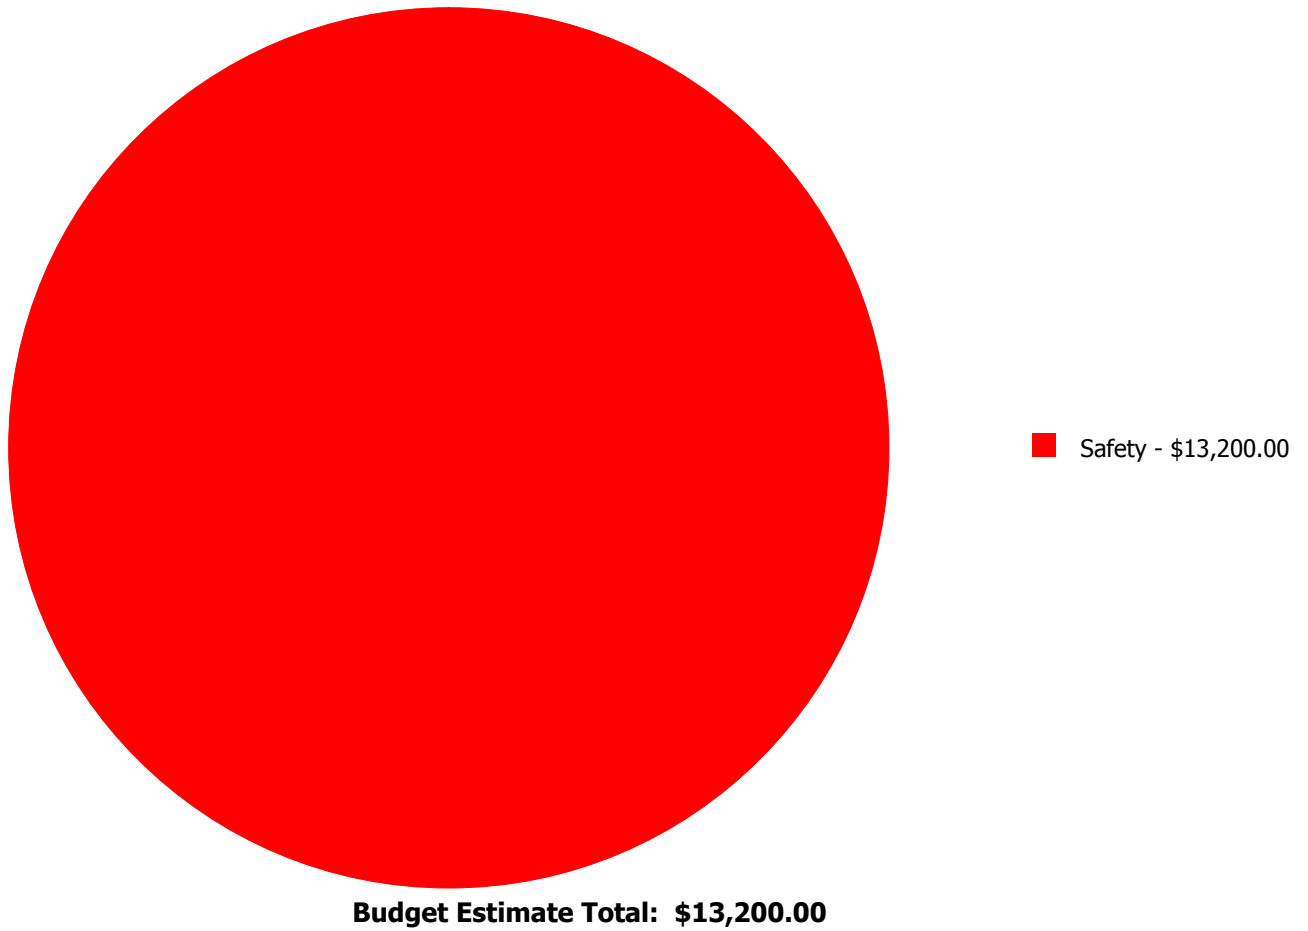
Deficiency Summary by Category

The following chart shows the total repair costs broken down by deficiency categories. Assessors assigned deficiencies to one of the following categories:

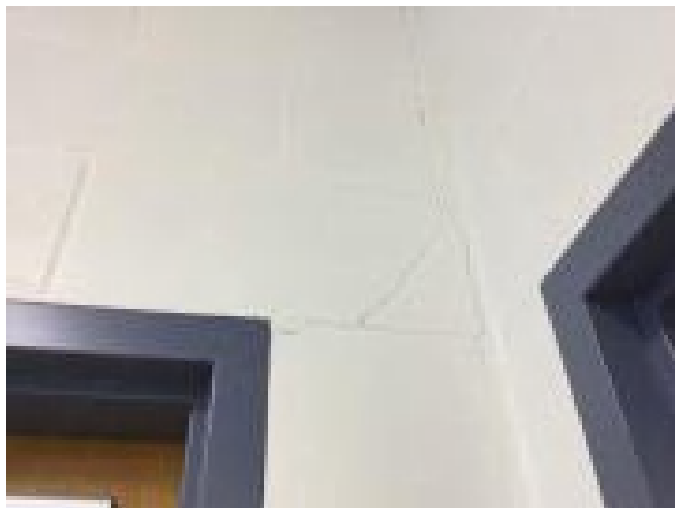
System: C1010 - Partitions

Location: Art Room and Room 238
Distress: Failing
Category: Safety
Priority: 1 - Currently Critical (Immediate)
Correction: Engineering Study
Qty: 1.00
Unit of Measure: Ea.
Estimate: \$13,200.00
Assessor Name: Somnath Das
Date Created: 02/01/2017

Notes: There are visible cracks on the partition wall which should be studied by a professional engineer.

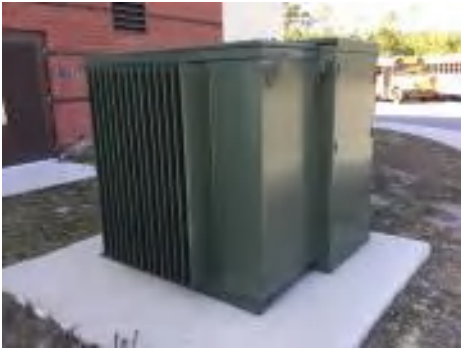
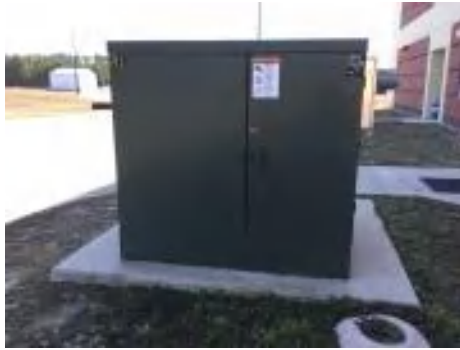
System: G4010 - Electrical Distribution

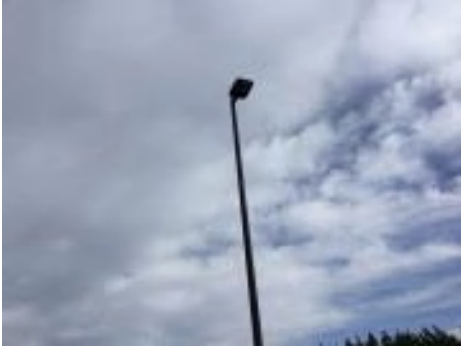
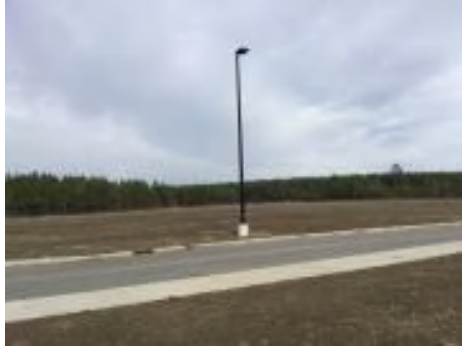
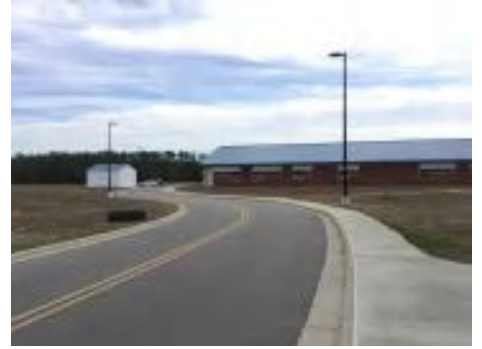
System: G4020 - Site Lighting

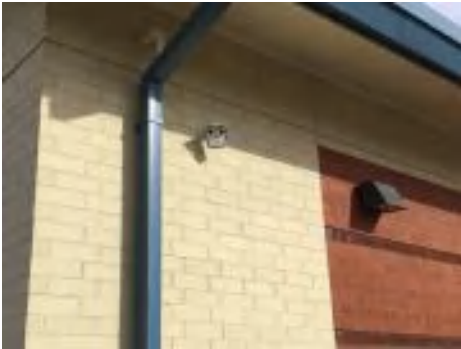
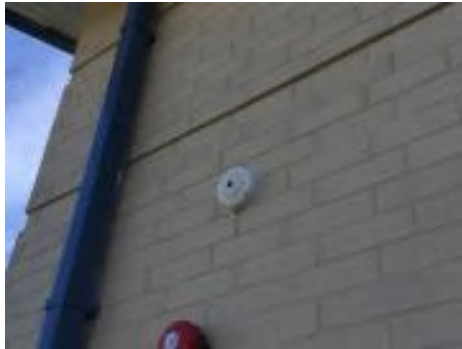
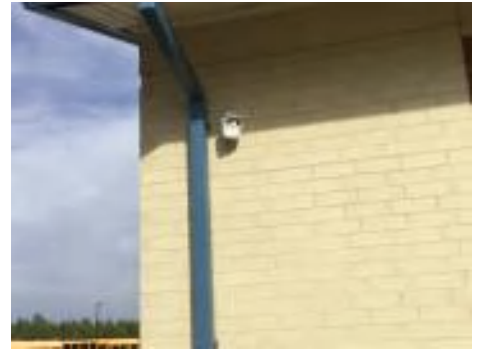
System: G4030 - Site Communications & Security

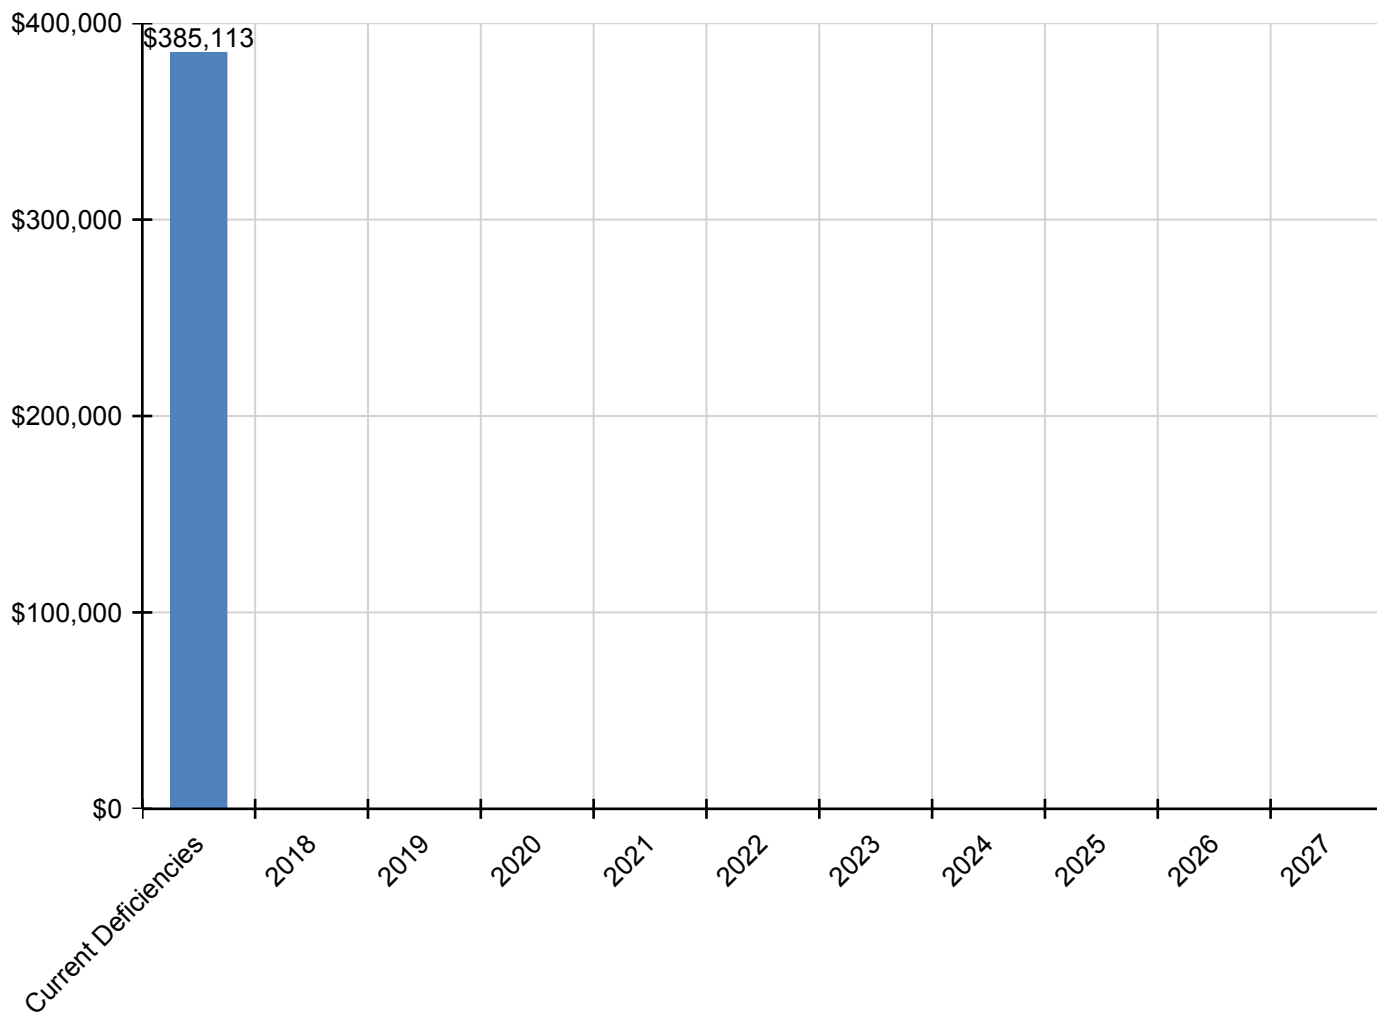
Forecasted Capital Renewal Requirement

The following chart shows the current building deficiencies and forecasting capital renewal or sustainment requirements over the next ten years.

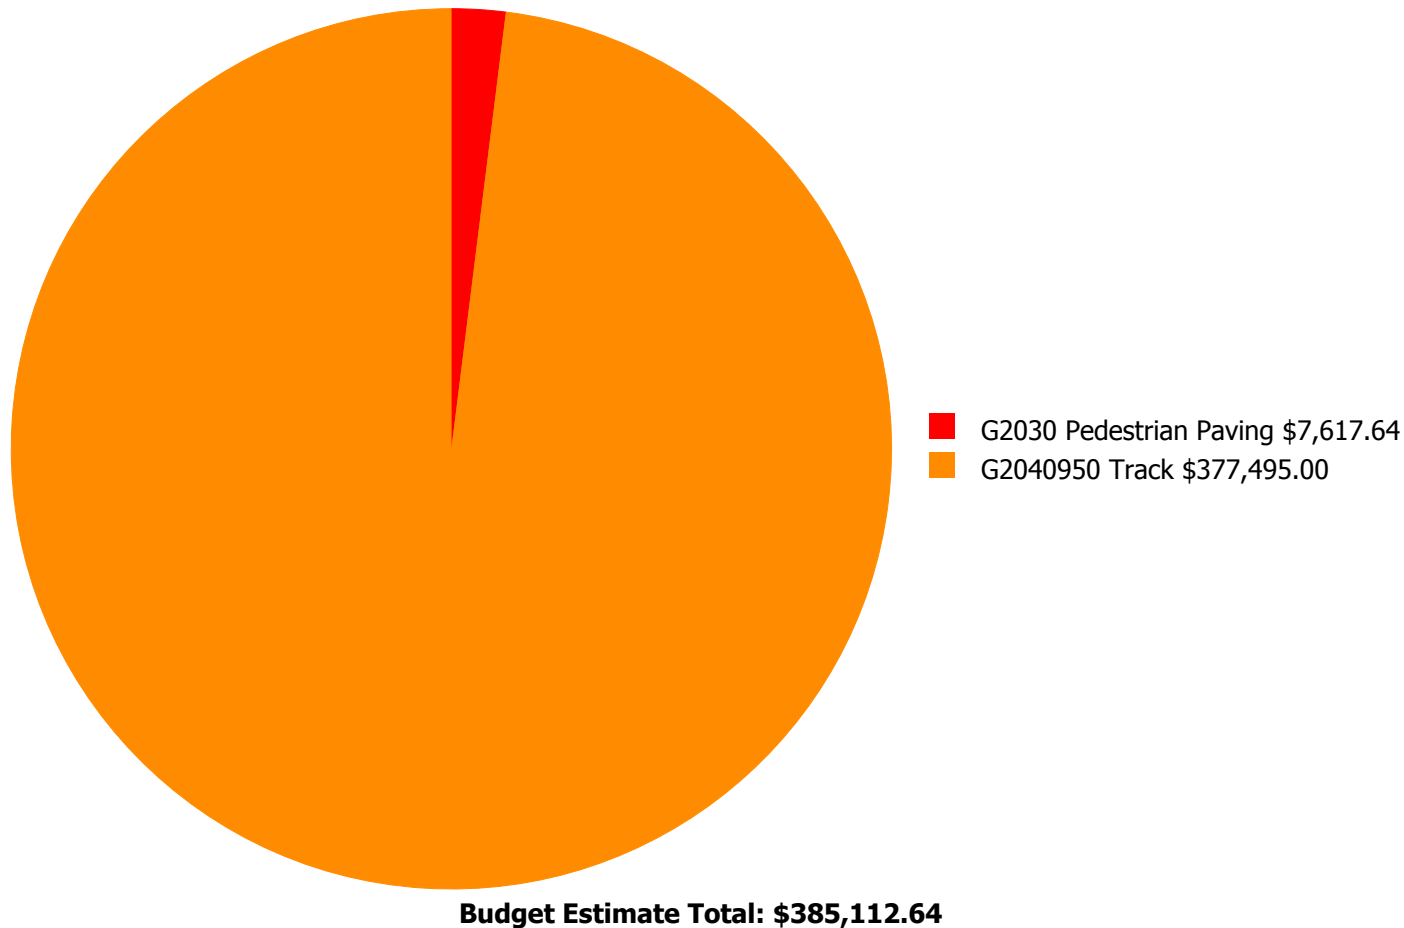
Deficiency Summary by System

Current deficiencies included assemblies that have reached or exceeded their design life or components of the assemblies that are in need of repair. Assemblies that have reached their design life are identified as current deficiencies and assigned the distress 'Beyond Useful Life'. The following chart lists all current deficiencies associated with this facility.

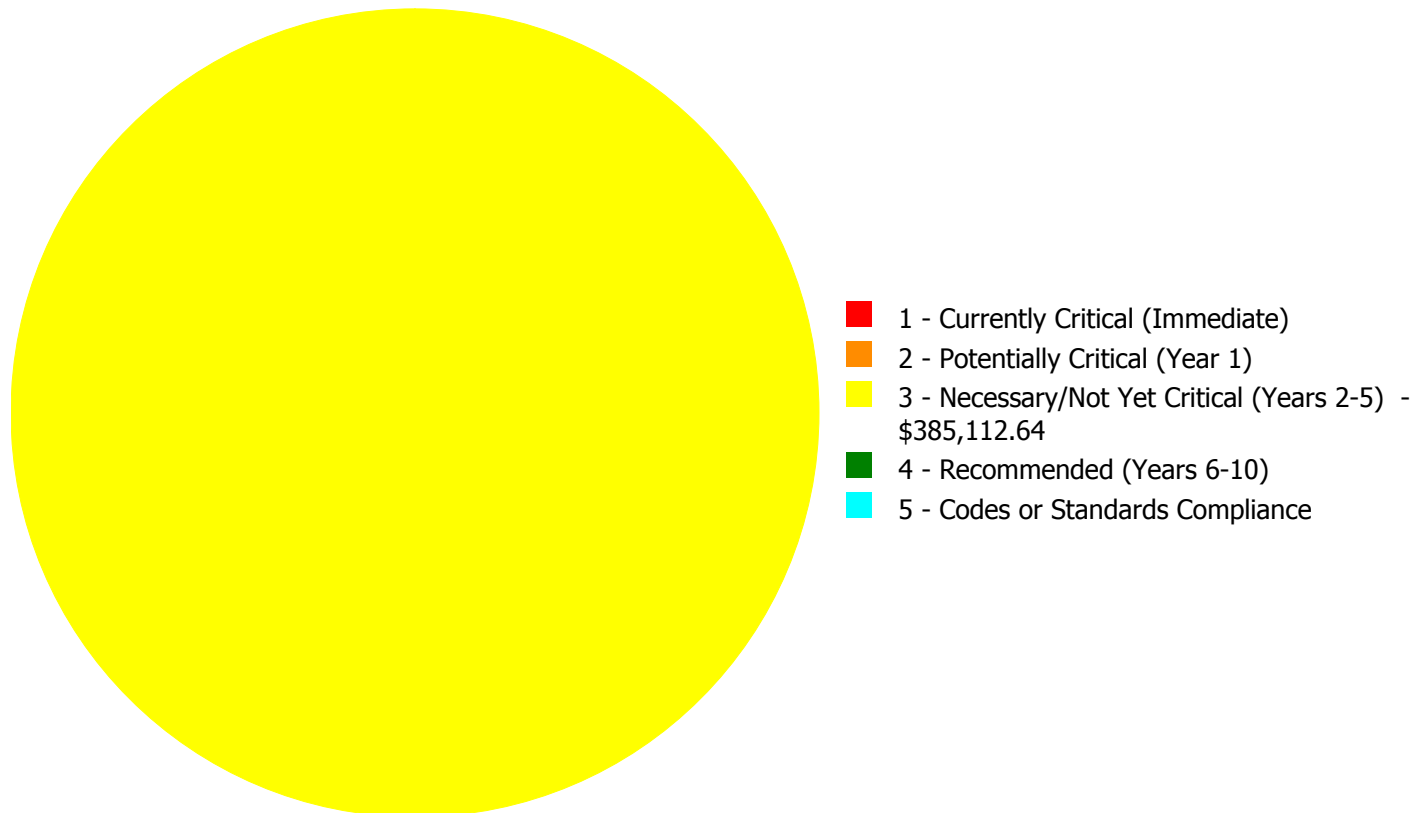
Deficiency Summary by Priority

The following chart shows the total repair costs broken down by priority. Assessors assigned deficiencies within eCOMET to one of the following priority categories:

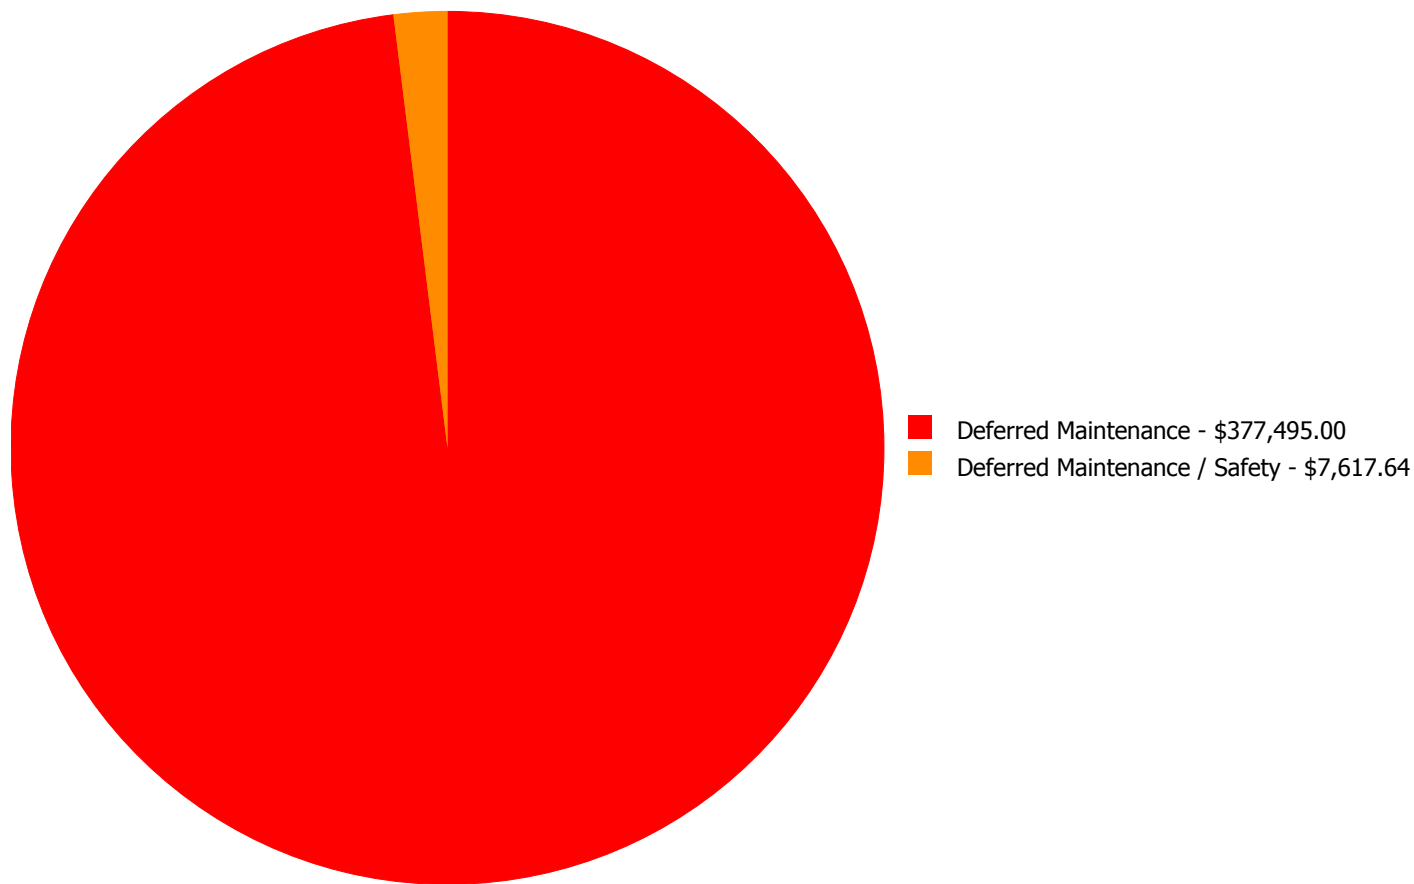
Deficiency Summary by Category

The following chart shows the total repair costs broken down by deficiency categories. Assessors assigned deficiencies to one of the following categories:

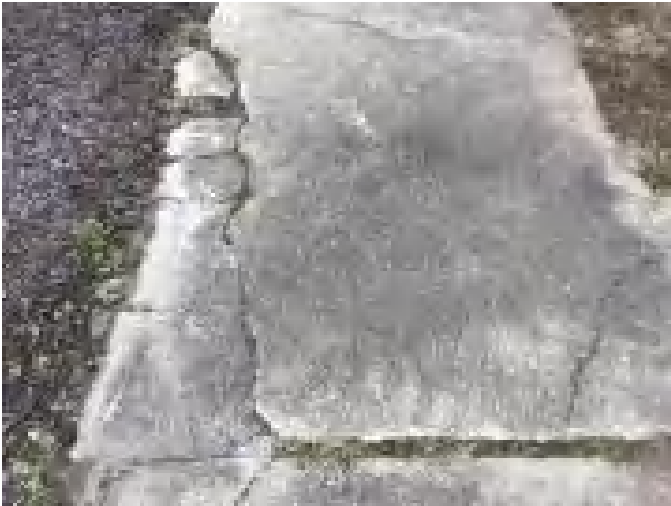
System: G2030 - Pedestrian Paving

Location: Site for the older buildings
Distress: Failing
Category: Deferred Maintenance / Safety
Priority: 3 - Necessary/Not Yet Critical (Years 2-5)
Correction: Remove and replace concrete sidewalk, 4' wide
Qty: 150.00
Unit of Measure: L.F.
Estimate: \$7,617.64
Assessor Name: Eduardo Lopez
Date Created: 02/02/2017

Notes: The pedestrian paving is cracked and level difference will cause tripping hazards, the pedestrian paving should be corrected.

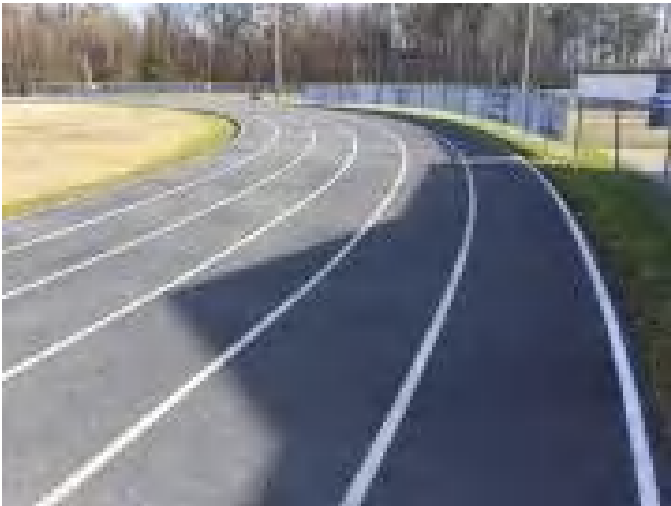
System: G2040950 - Track

Location: Site
Distress: Beyond Service Life
Category: Deferred Maintenance
Priority: 3 - Necessary/Not Yet Critical (Years 2-5)
Correction: Renew System
Qty: 192,796.00
Unit of Measure: S.F.
Estimate: \$377,495.00
Assessor Name: Eduardo Lopez
Date Created: 02/08/2017

Notes: The track has asphalt top and is considered a hazard, thus the students are not allowed to use the track. The track should be replaced.
