NC School District/220 Clay County/High School

Hayesville High

Campus Assessment Report

March 7, 2017

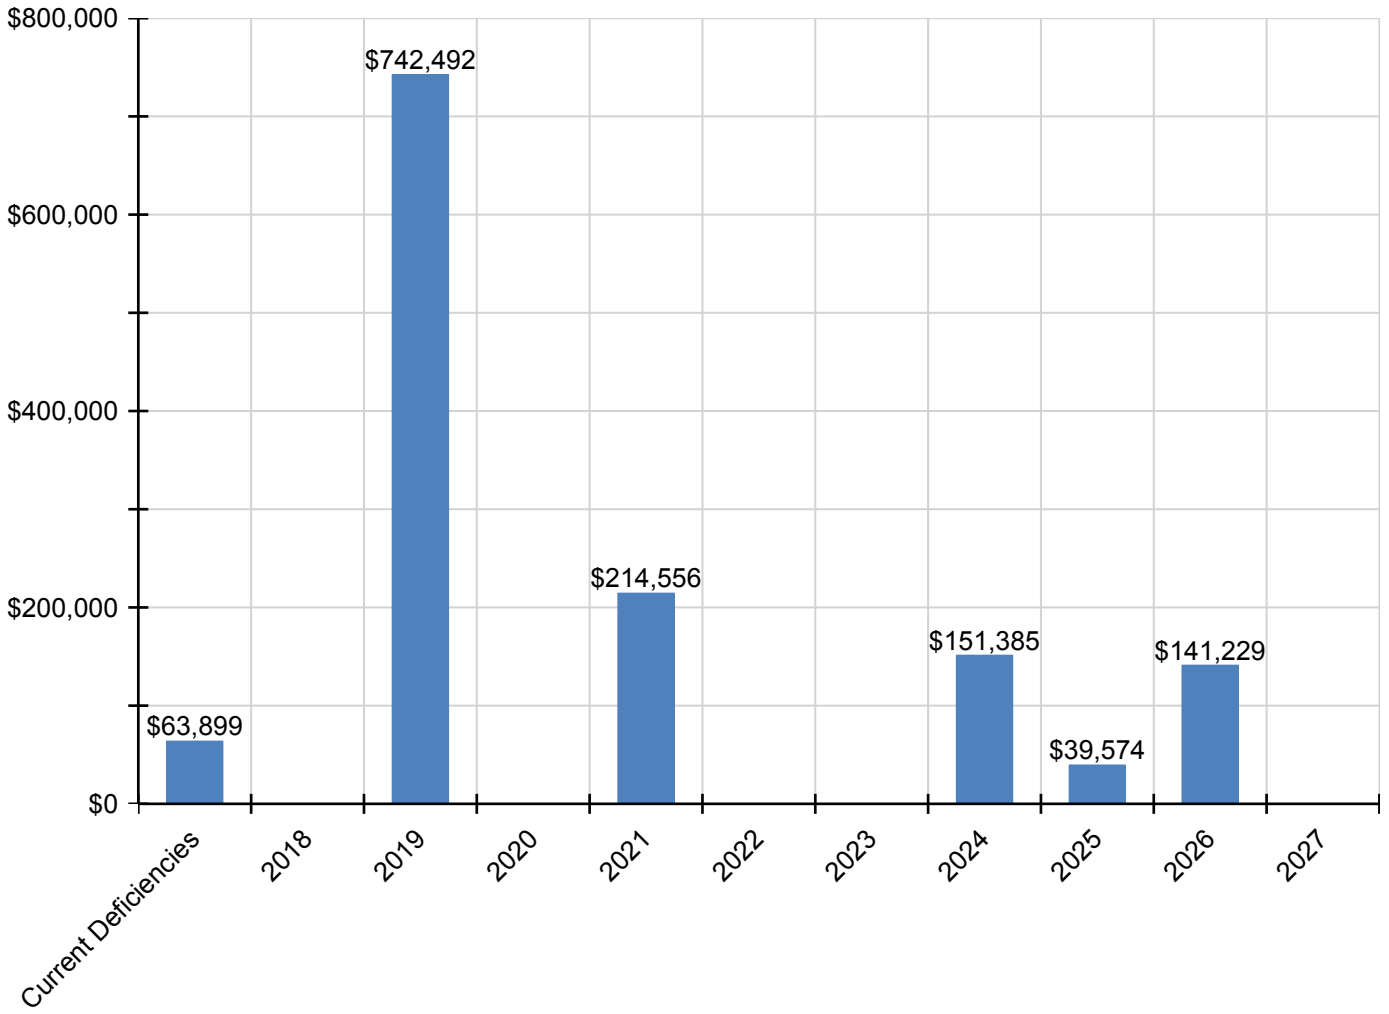
Forecasted Capital Renewal Requirement

The following chart shows the current building deficiencies and forecasting capital renewal or sustainment requirements over the next ten years.

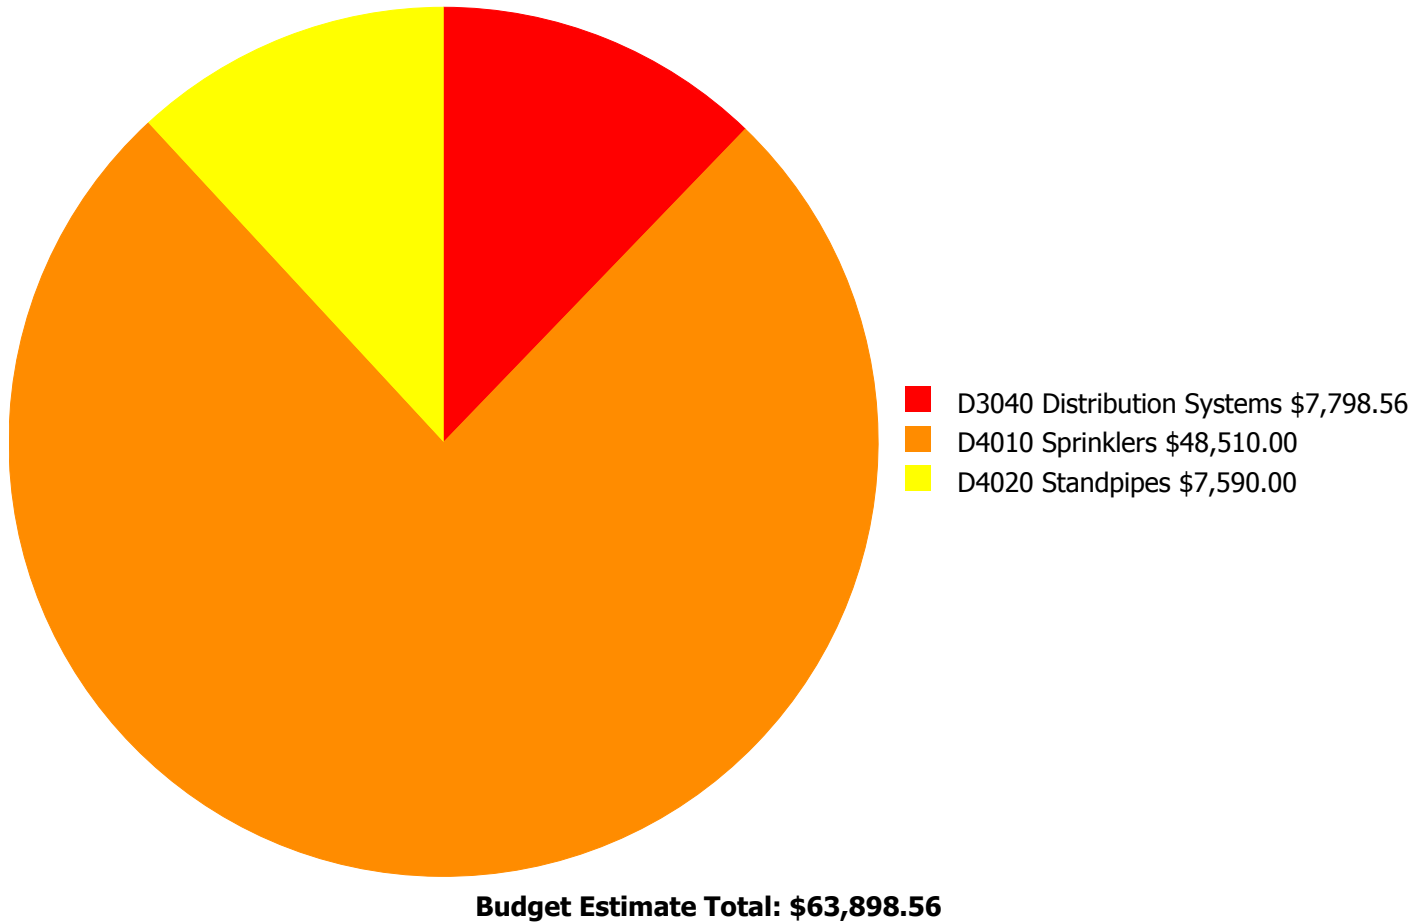
Deficiency Summary by System

Current deficiencies included assemblies that have reached or exceeded their design life or components of the assemblies that are in need of repair. Assemblies that have reached their design life are identified as current deficiencies and assigned the distress 'Beyond Useful Life'. The following chart lists all current deficiencies associated with this facility.

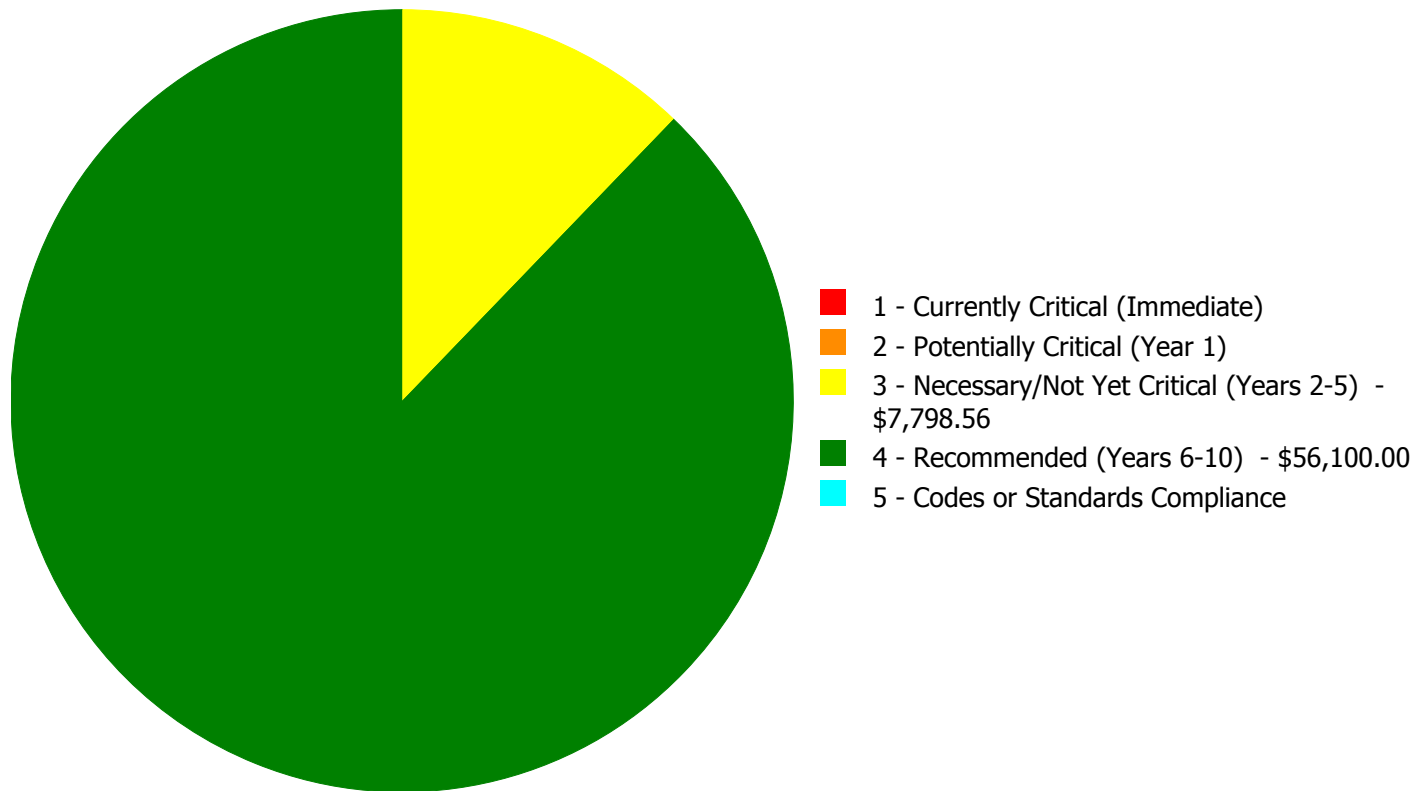
Deficiency Summary by Priority

The following chart shows the total repair costs broken down by priority. Assessors assigned deficiencies within eCOMET to one of the following priority categories:

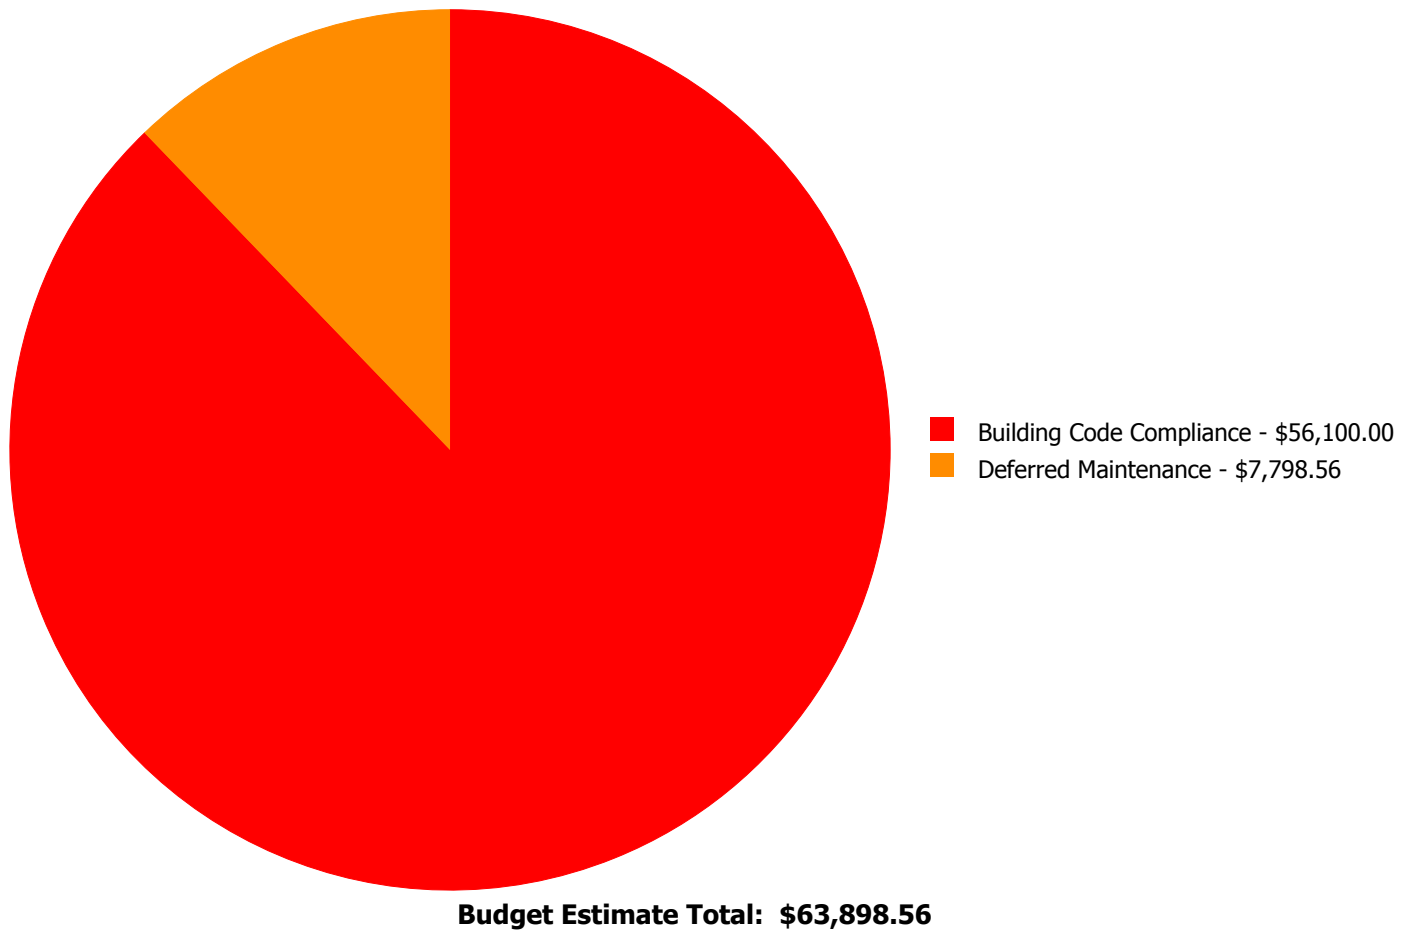
Deficiency Summary by Category

The following chart shows the total repair costs broken down by deficiency categories. Assessors assigned deficiencies to one of the following categories:

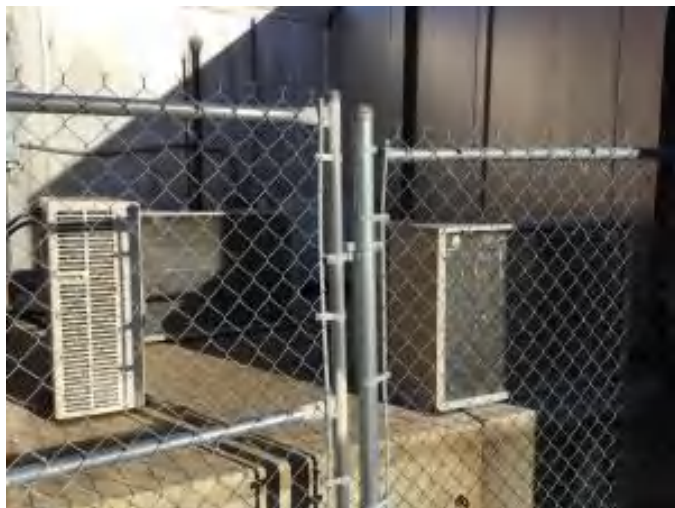
System: D3040 - Distribution Systems

Location: 1972 Cafeteria
Distress: Beyond Service Life
Category: Deferred Maintenance
Priority: 3 - Necessary/Not Yet Critical (Years 2-5)
Correction: Replace fan coil unit, 5 ton
Qty: 2.00
Unit of Measure: Ea.
Estimate: \$7,798.56
Assessor Name: Terence Davis
Date Created: 02/24/2017

Notes: The DX units are passed their useful life and should be replaced.

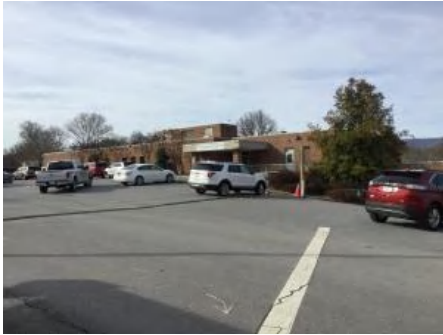
1). South Elevation - Jan 27, 2017

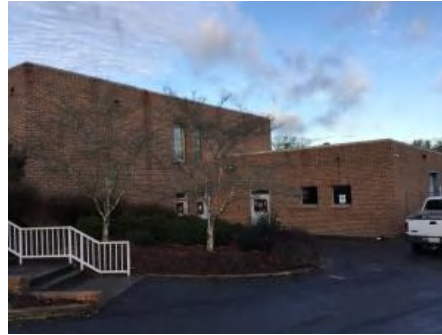
2). West Elevation - Jan 27, 2017

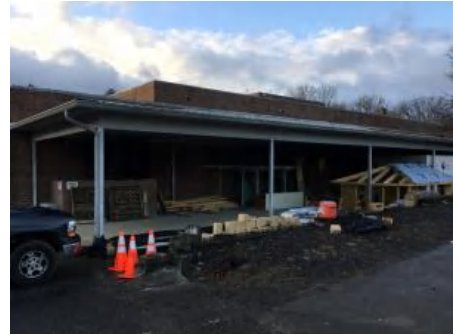
3). North Elevation - Jan 27, 2017

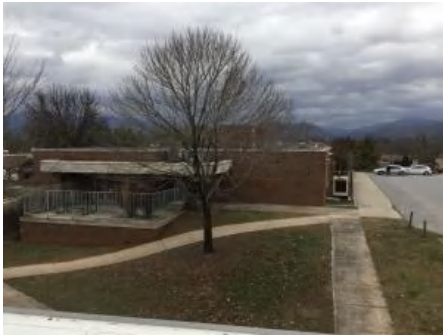
4). East Elevation - Jan 27, 2017

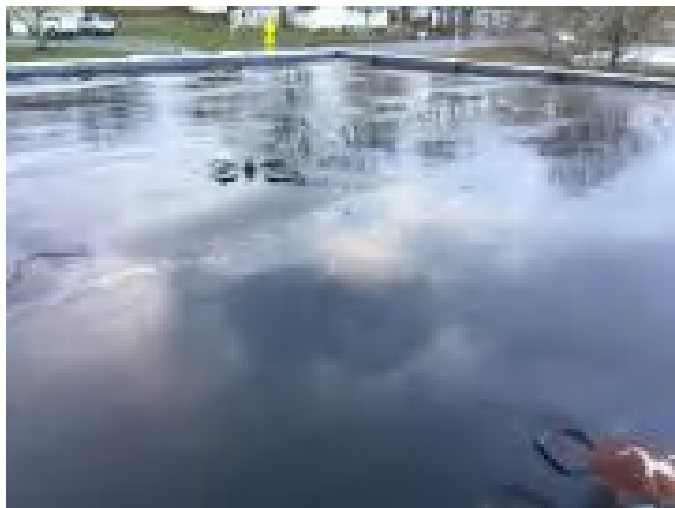
System: B3010120 - Single Ply Membrane

Location: Roof
Distress: Damaged
Category: Deferred Maintenance
Priority: 2 - Potentially Critical (Year 1)
Correction: Renew System
Qty: 25,270.00
Unit of Measure: S.F.
Estimate: \$264,577.00
Assessor Name: Eduardo Lopez
Date Created: 02/09/2017

Notes: The roof covering has deteriorated flashing, several repairs, empty pitch pockets, open membrane seams, debris and ponding, open caulk joints, loss of top surface, blisters, damaged and should be replaced.

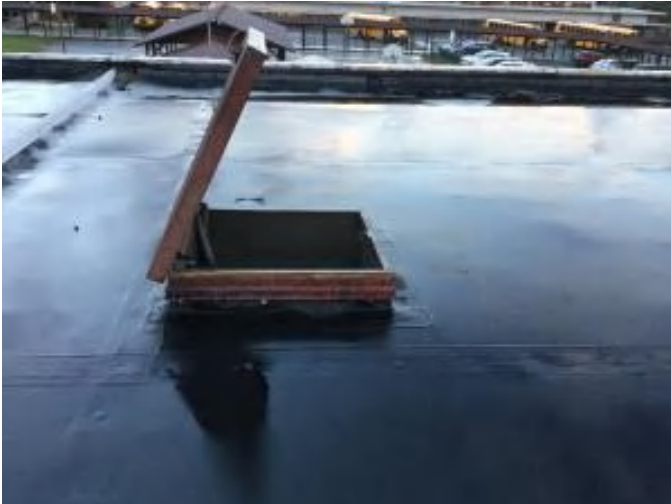
System: B3020 - Roof Openings

Location: Roof
Distress: Beyond Service Life
Category: Deferred Maintenance
Priority: 3 - Necessary/Not Yet Critical (Years 2-5)
Correction: Renew System
Qty: 25,270.00
Unit of Measure: S.F.
Estimate: \$13,343.00
Assessor Name: Eduardo Lopez
Date Created: 02/27/2017

Notes: Roof opening should be inspected and repair as roof is being replaced. Install an expanded post or safety rails.

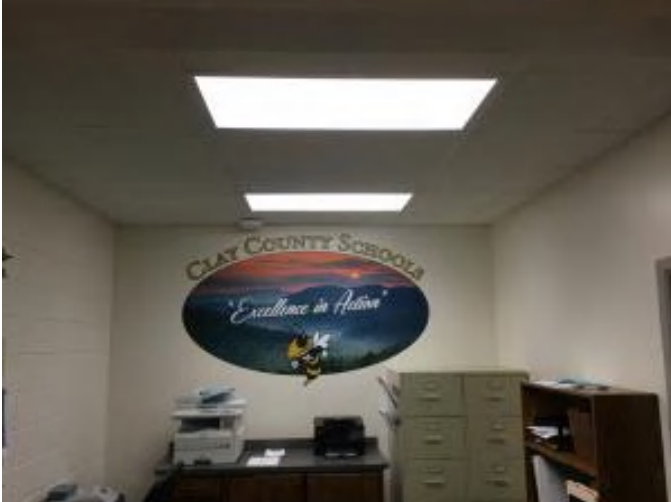
System: C3030 - Ceiling Finishes

Location: Throughout the building
Distress: Damaged
Category: Deferred Maintenance
Priority: 3 - Necessary/Not Yet Critical (Years 2-5)
Correction: Renew System
Qty: 25,270.00
Unit of Measure: S.F.
Estimate: \$314,106.00
Assessor Name: Eduardo Lopez
Date Created: 02/09/2017

Notes: The acoustical ceiling tiles and grid system is aged and should be replaced.

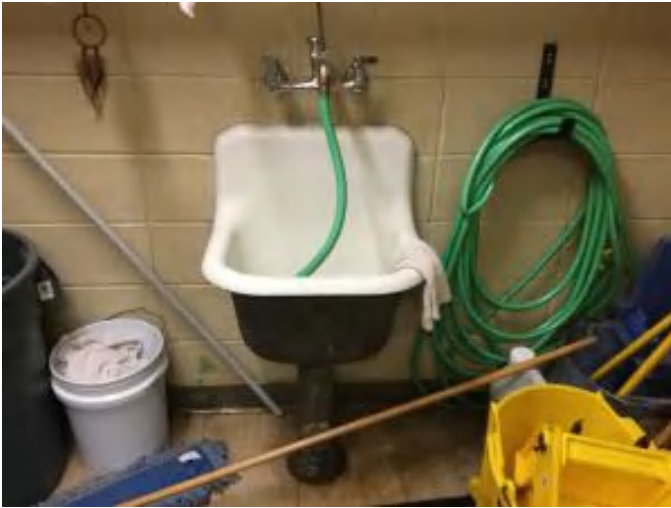
System: D2010 - Plumbing Fixtures

Location: Restrooms
Distress: Inadequate
Category: Building Code Compliance
Priority: 3 - Necessary/Not Yet Critical (Years 2-5)
Correction: Renew System
Qty: 25,270.00
Unit of Measure: S.F.
Estimate: \$262,960.00
Assessor Name: Eduardo Lopez
Date Created: 02/09/2017

Notes: The plumbing fixtures are original, not efficient or low flow fixtures.

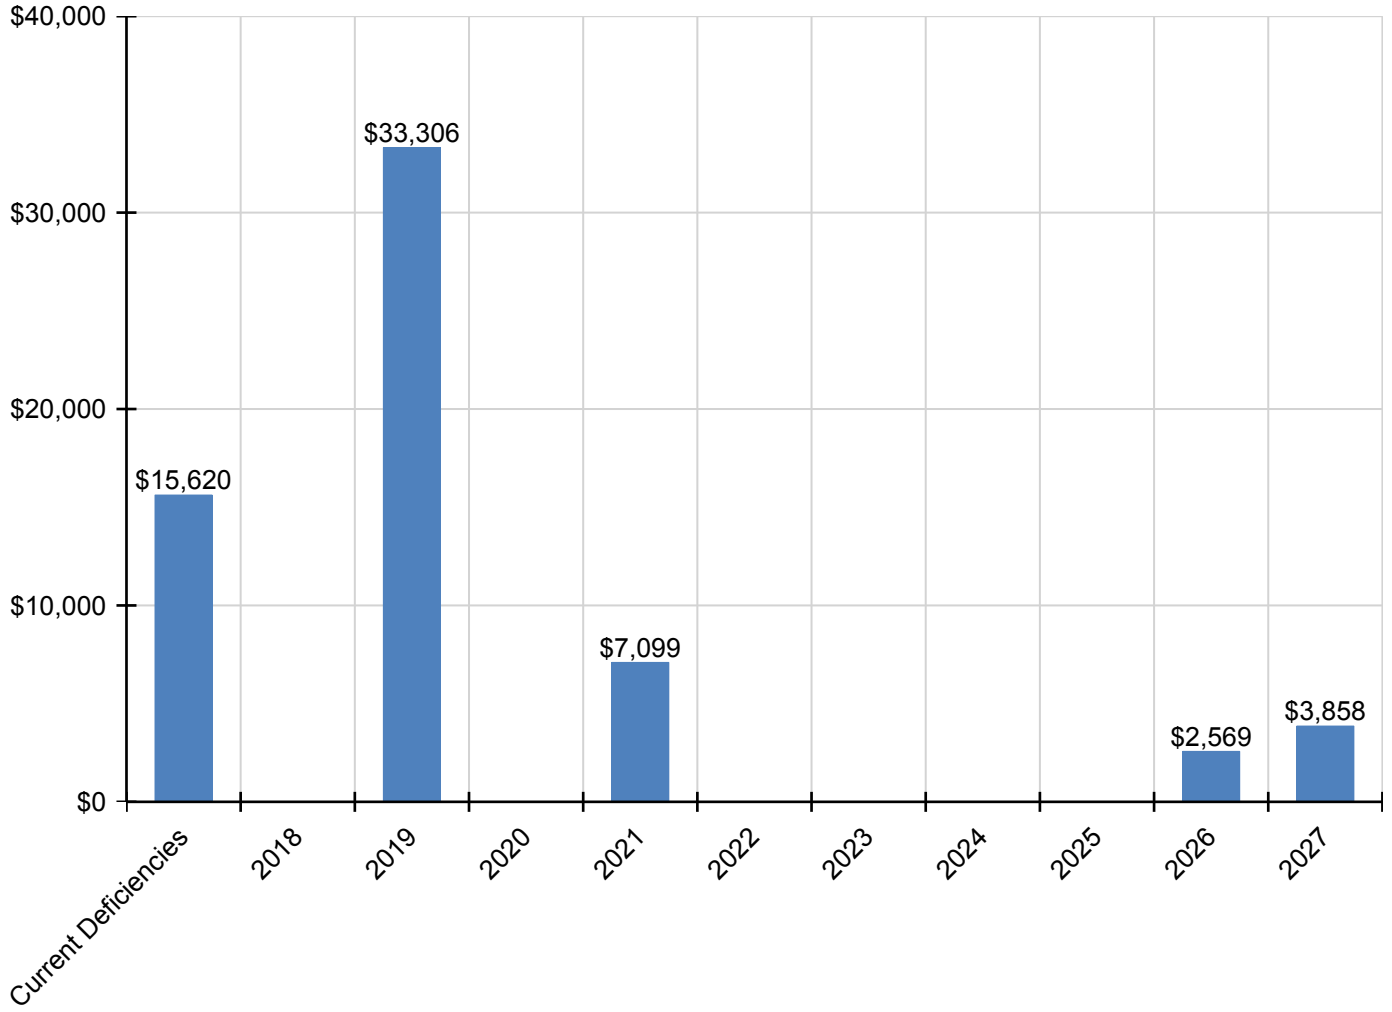
Forecasted Capital Renewal Requirement

The following chart shows the current building deficiencies and forecasting capital renewal or sustainment requirements over the next ten years.

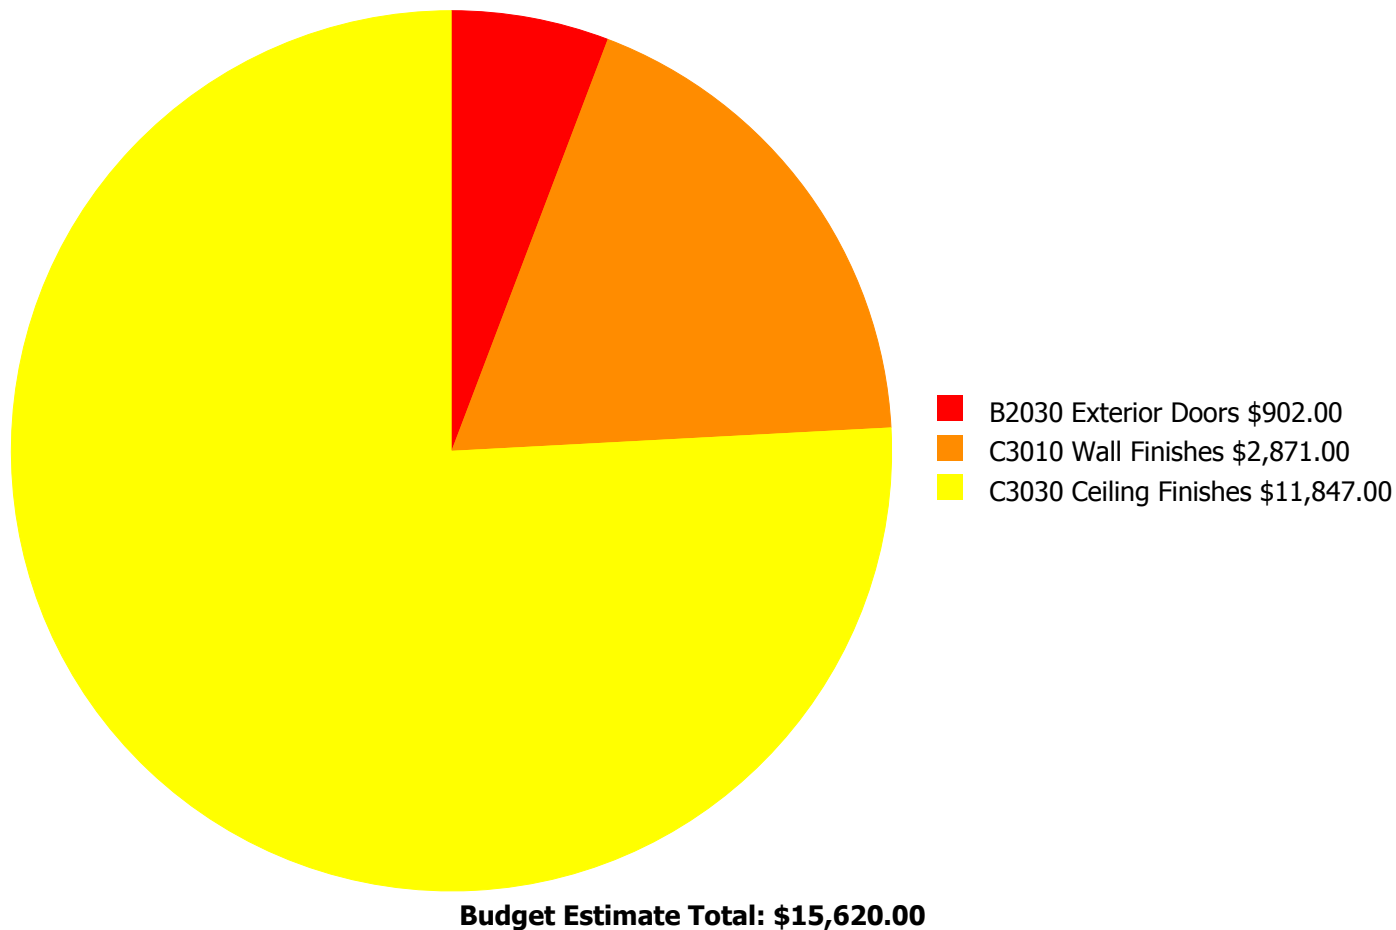
Deficiency Summary by System

Current deficiencies included assemblies that have reached or exceeded their design life or components of the assemblies that are in need of repair. Assemblies that have reached their design life are identified as current deficiencies and assigned the distress 'Beyond Useful Life'. The following chart lists all current deficiencies associated with this facility.

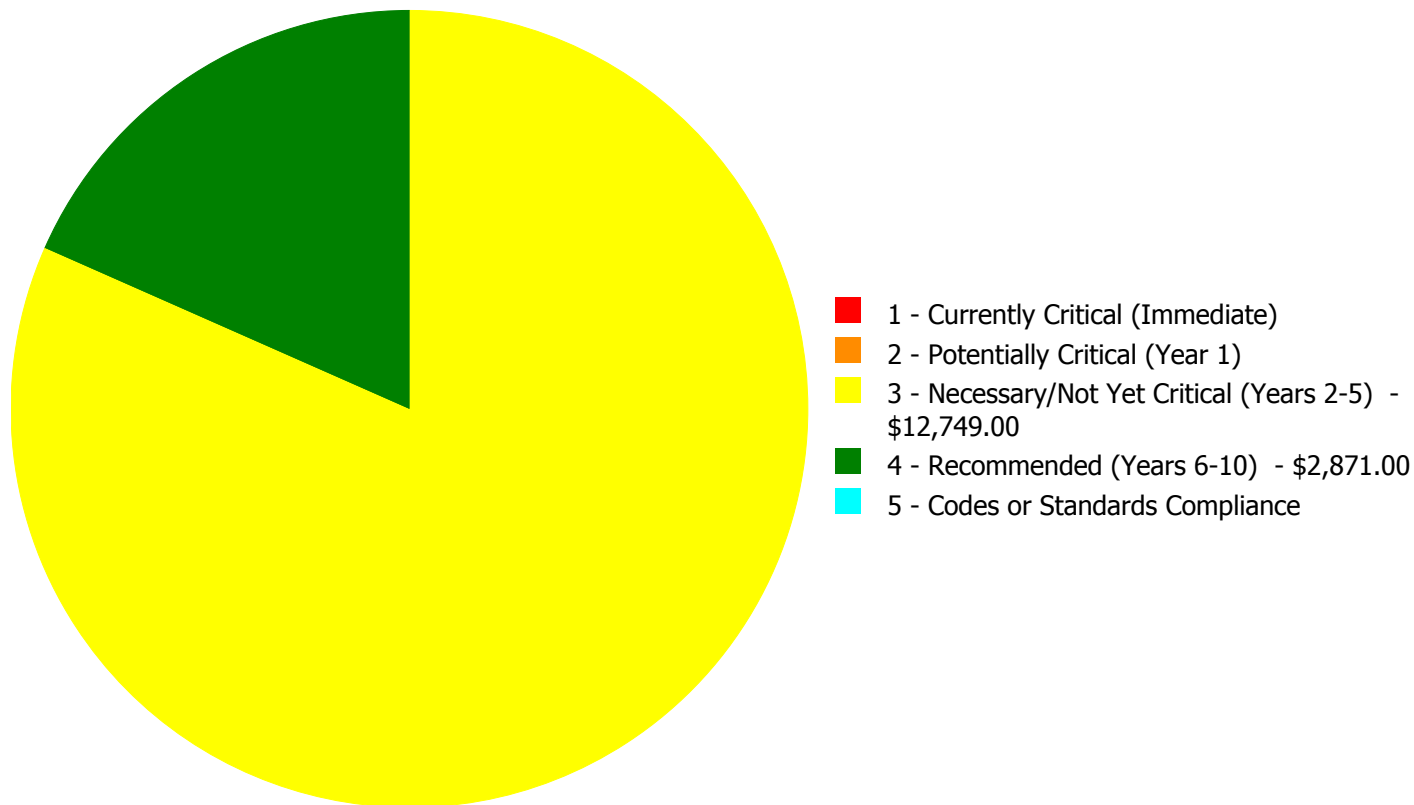
Deficiency Summary by Priority

The following chart shows the total repair costs broken down by priority. Assessors assigned deficiencies within eCOMET to one of the following priority categories:

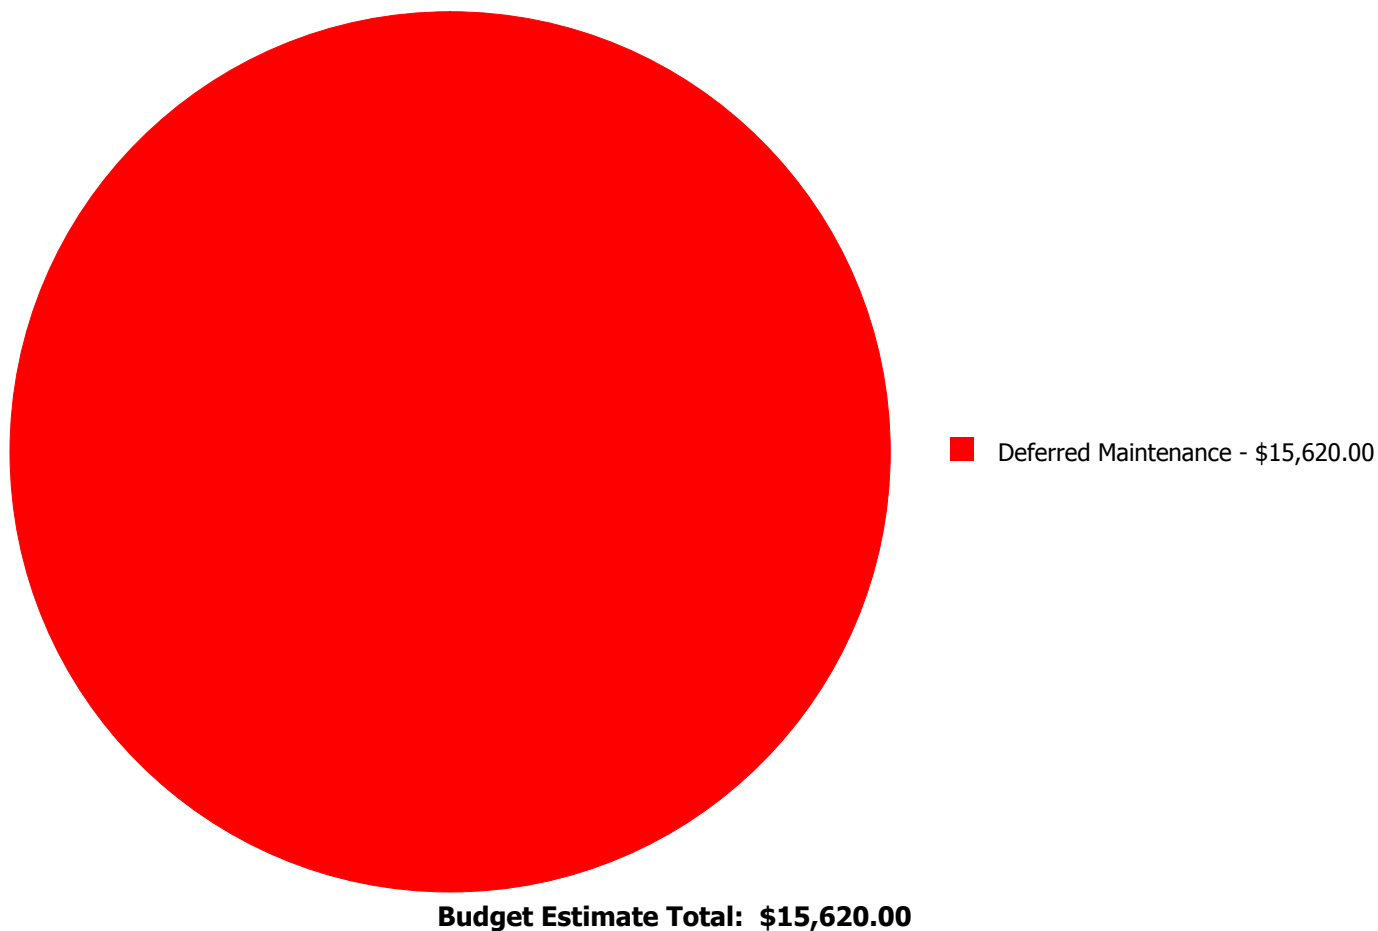
Deficiency Summary by Category

The following chart shows the total repair costs broken down by deficiency categories. Assessors assigned deficiencies to one of the following categories:

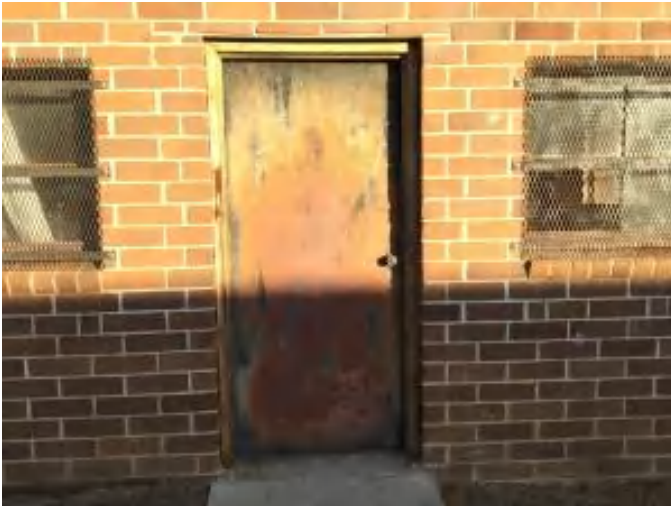
System: B2030 - Exterior Doors

Location: Exterior
Distress: Damaged
Category: Deferred Maintenance
Priority: 3 - Necessary/Not Yet Critical (Years 2-5)
Correction: Renew System
Qty: 1,000.00
Unit of Measure: S.F.
Estimate: \$902.00
Assessor Name: Terence Davis
Date Created: 02/24/2017

Notes: Exterior doors are damaged.

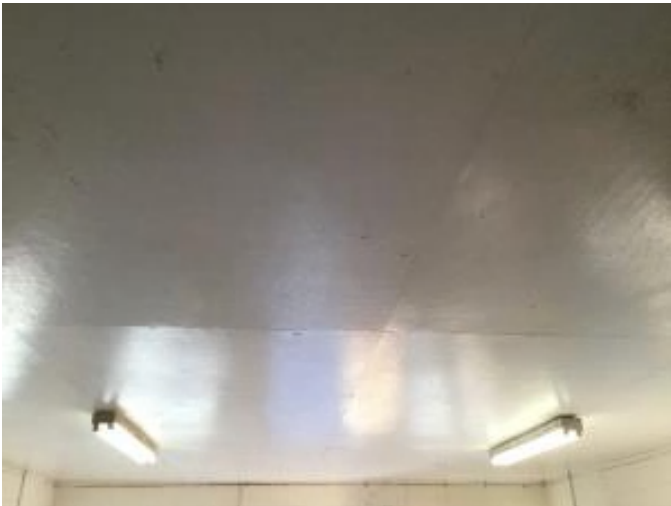
System: C3030 - Ceiling Finishes

Location: Interior
Distress: Damaged
Category: Deferred Maintenance
Priority: 3 - Necessary/Not Yet Critical (Years 2-5)
Correction: Renew System
Qty: 1,000.00
Unit of Measure: S.F.
Estimate: \$11,847.00
Assessor Name: Terence Davis
Date Created: 02/09/2017

Notes: The original painted ceiling finish is aged, chipped, stained and should be replaced.

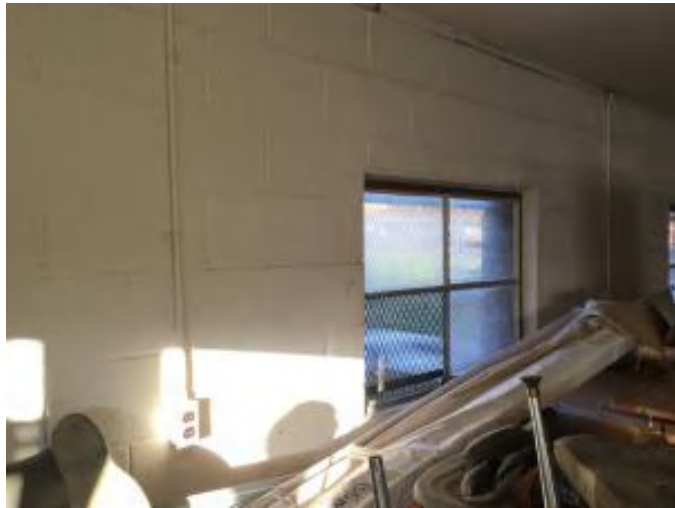
System: C3010 - Wall Finishes

Location: Interior
Distress: Damaged
Category: Deferred Maintenance
Priority: 4 - Recommended (Years 6-10)
Correction: Renew System
Qty: 1,000.00
Unit of Measure: S.F.
Estimate: \$2,871.00
Assessor Name: Terence Davis
Date Created: 02/14/2017

Notes: The wall paint is aged, scuffed and should be re-painted.

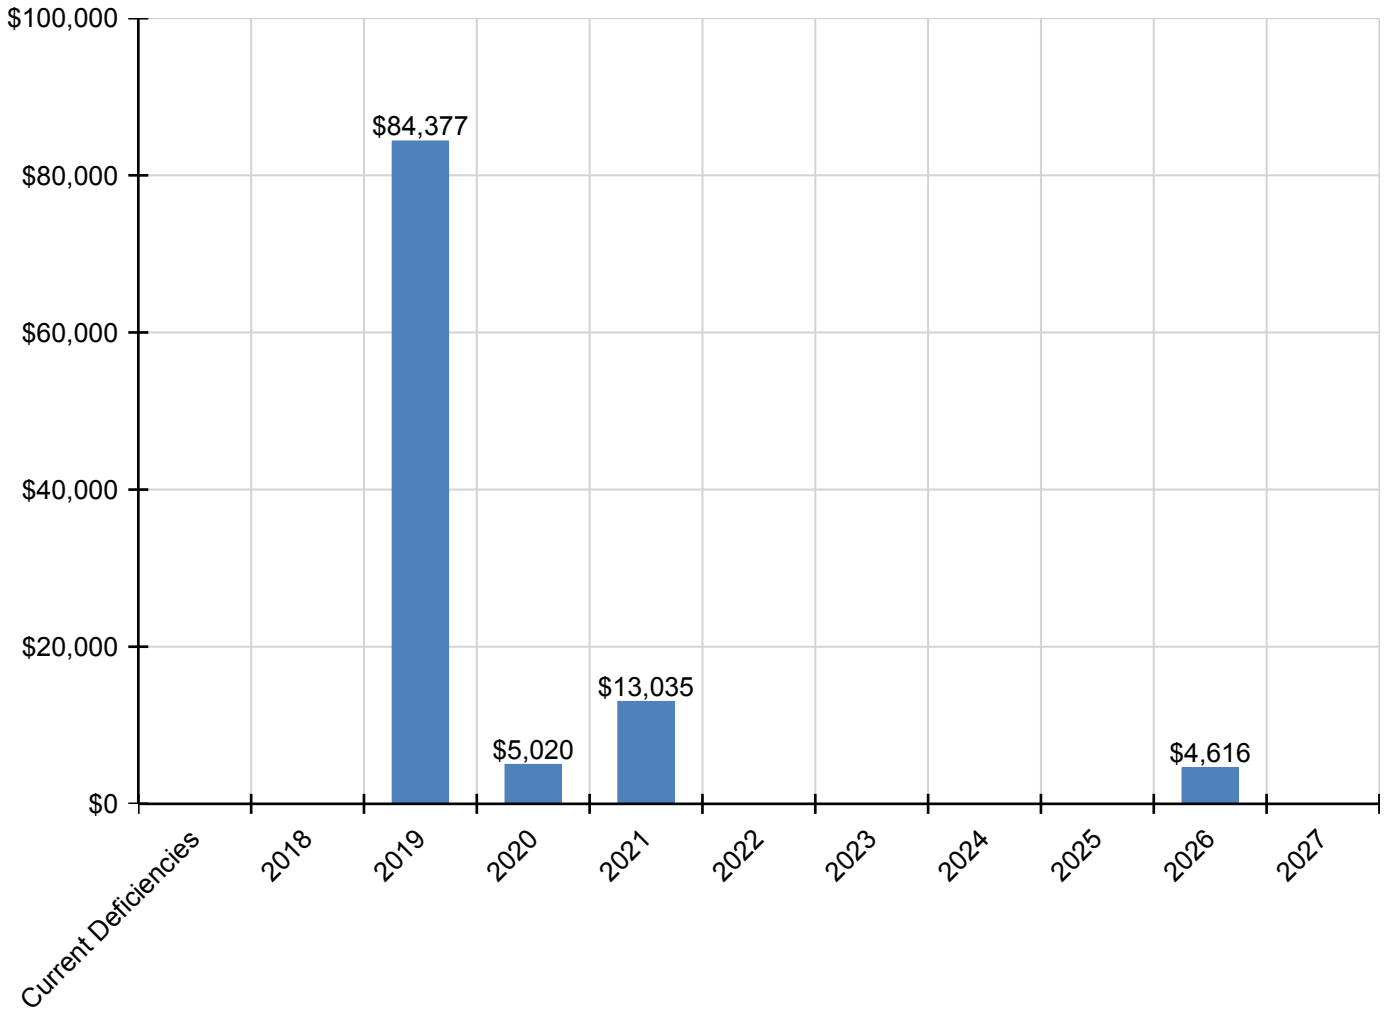
Forecasted Capital Renewal Requirement

The following chart shows the current building deficiencies and forecasting capital renewal or sustainment requirements over the next ten years.

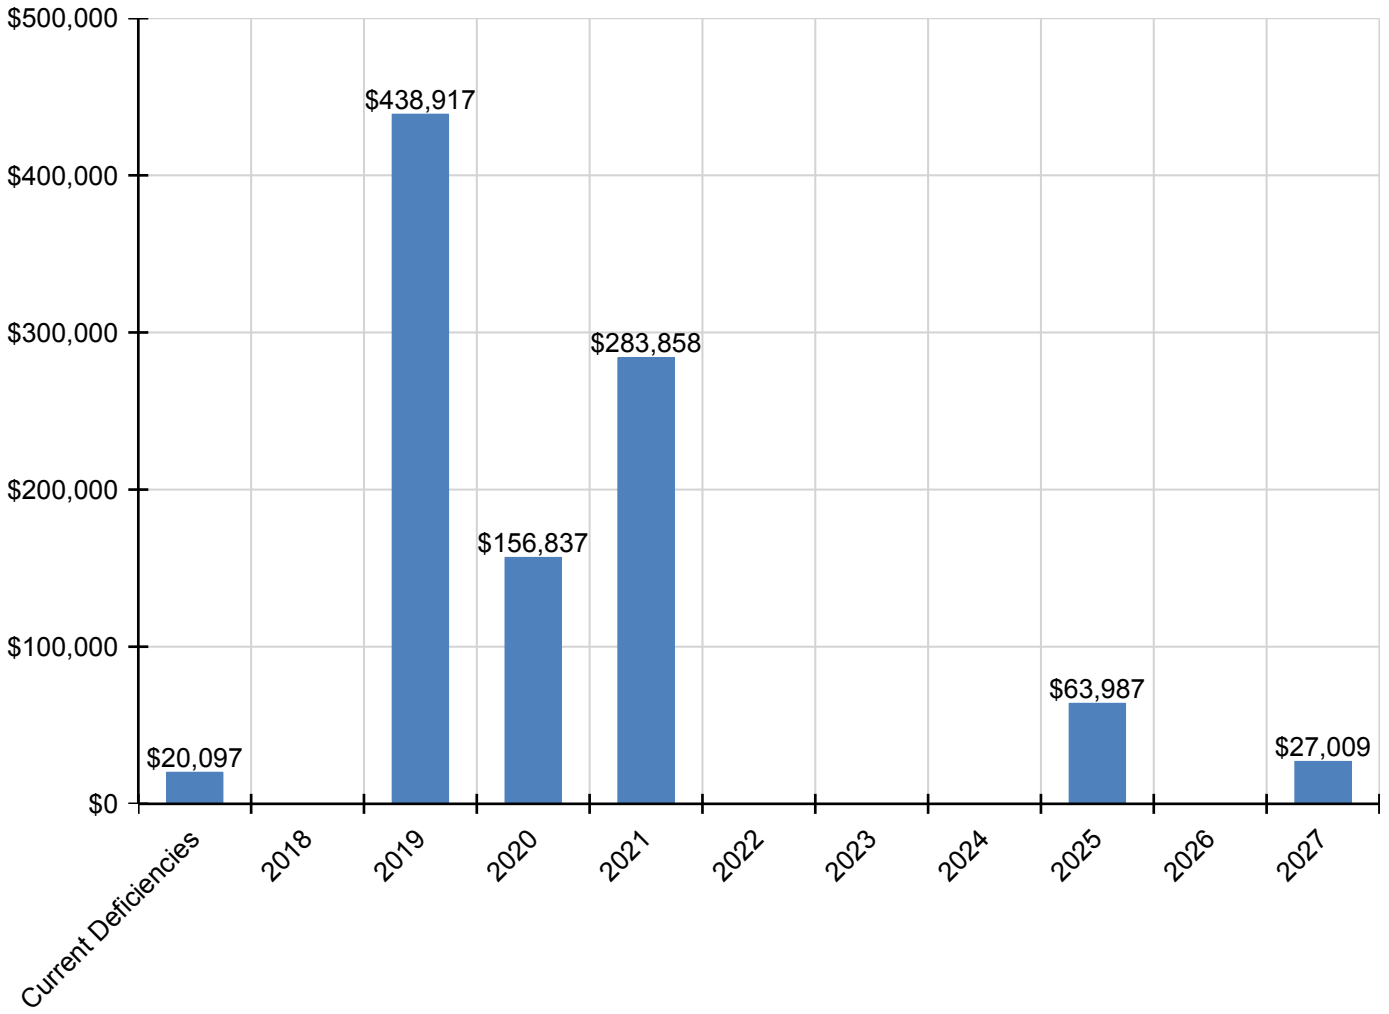
Forecasted Capital Renewal Requirement

The following chart shows the current building deficiencies and forecasting capital renewal or sustainment requirements over the next ten years.

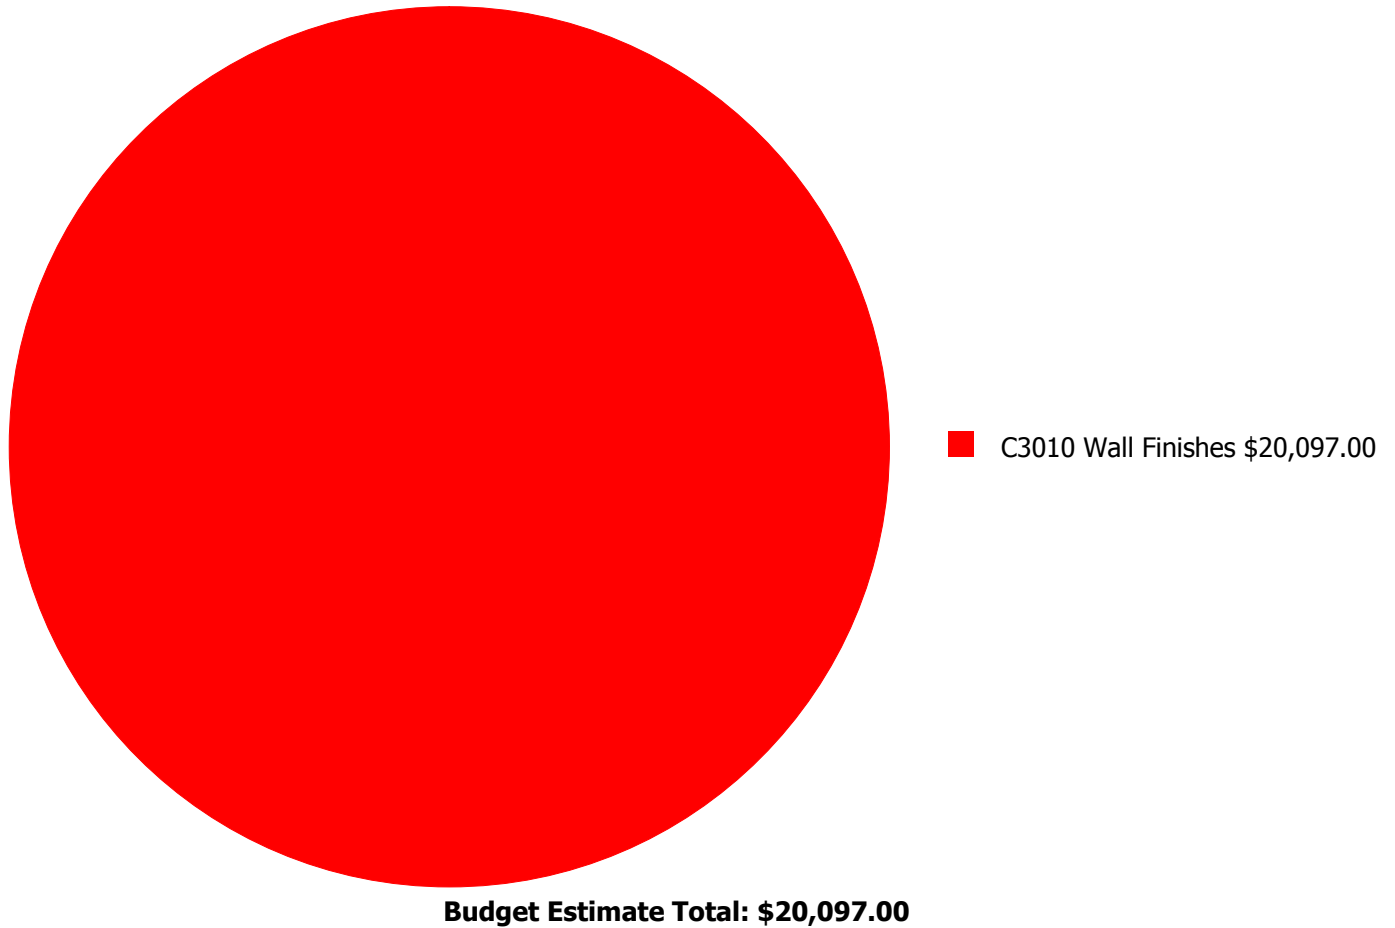
Deficiency Summary by System

Current deficiencies included assemblies that have reached or exceeded their design life or components of the assemblies that are in need of repair. Assemblies that have reached their design life are identified as current deficiencies and assigned the distress 'Beyond Useful Life'. The following chart lists all current deficiencies associated with this facility.

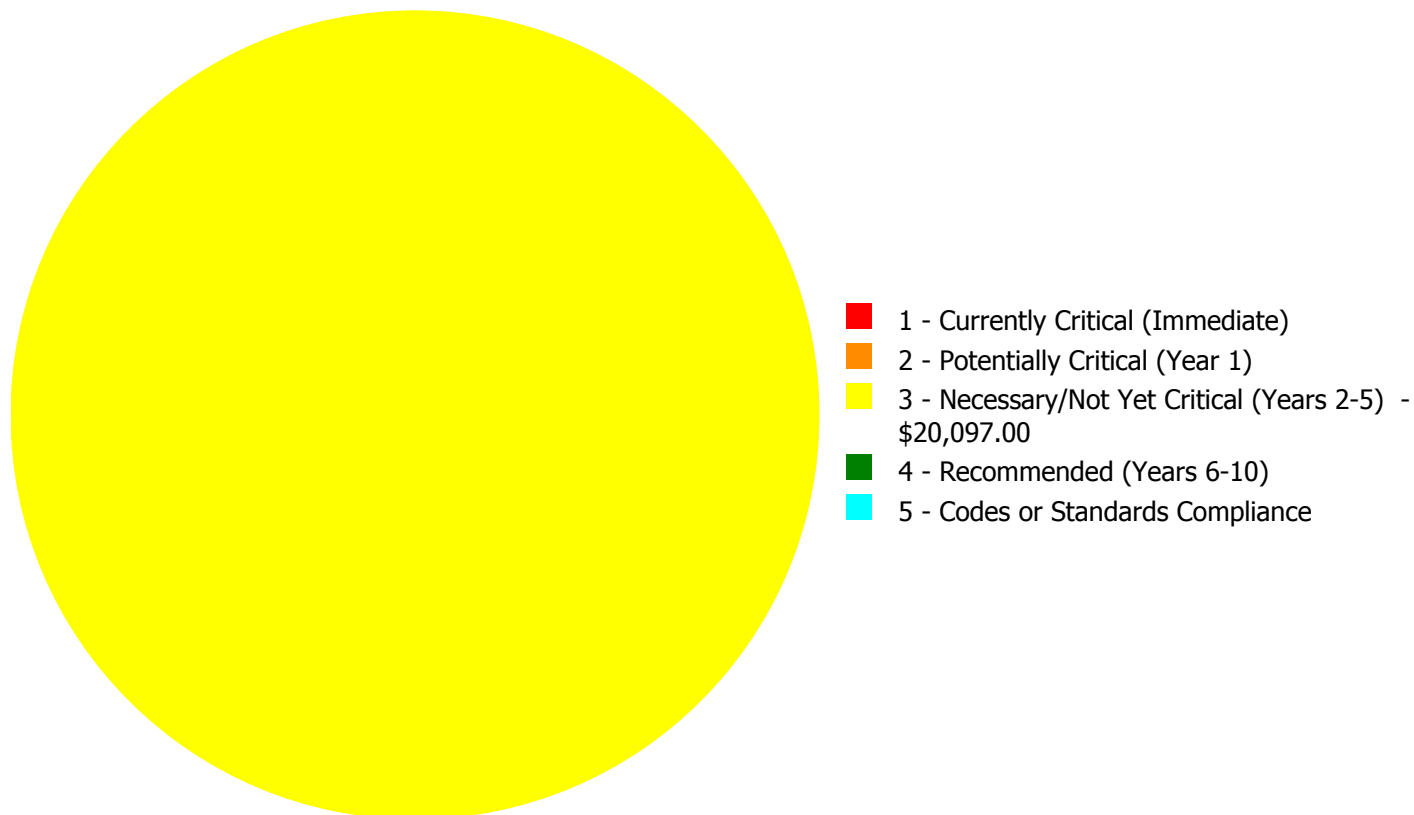
Deficiency Summary by Priority

The following chart shows the total repair costs broken down by priority. Assessors assigned deficiencies within eCOMET to one of the following priority categories:

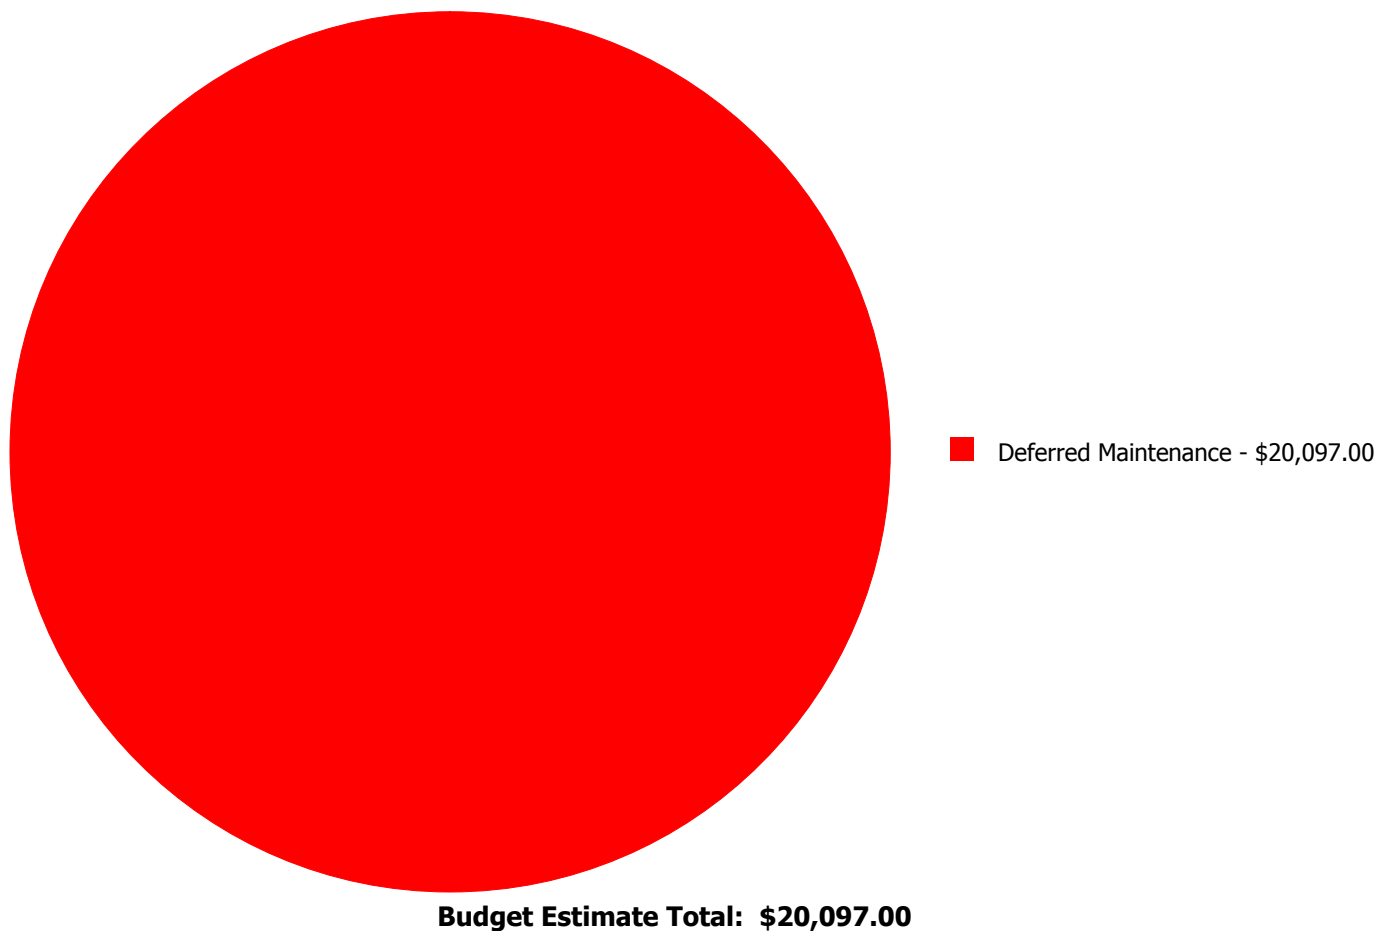
Deficiency Summary by Category

The following chart shows the total repair costs broken down by deficiency categories. Assessors assigned deficiencies to one of the following categories:

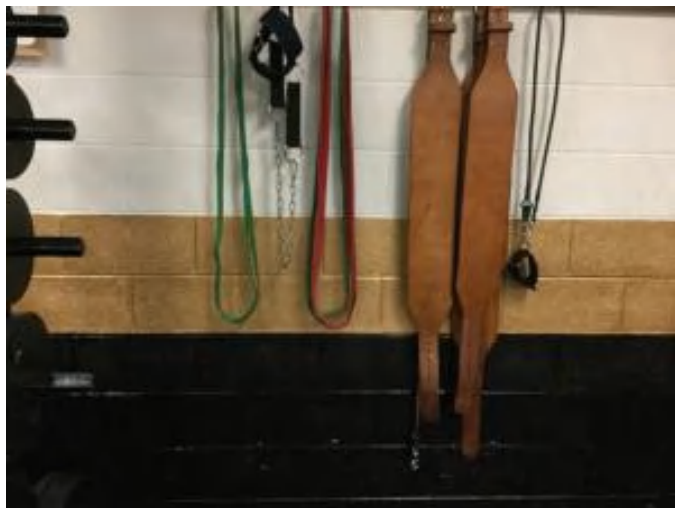
System: C3010 - Wall Finishes

Location: Throughout the building
Distress: Damaged
Category: Deferred Maintenance
Priority: 3 - Necessary/Not Yet Critical (Years 2-5)
Correction: Renew System
Qty: 7,000.00
Unit of Measure: S.F.
Estimate: \$20,097.00
Assessor Name: Eduardo Lopez
Date Created: 02/07/2017

Notes: The wall paint is aged, scuffed and should be re-painted.

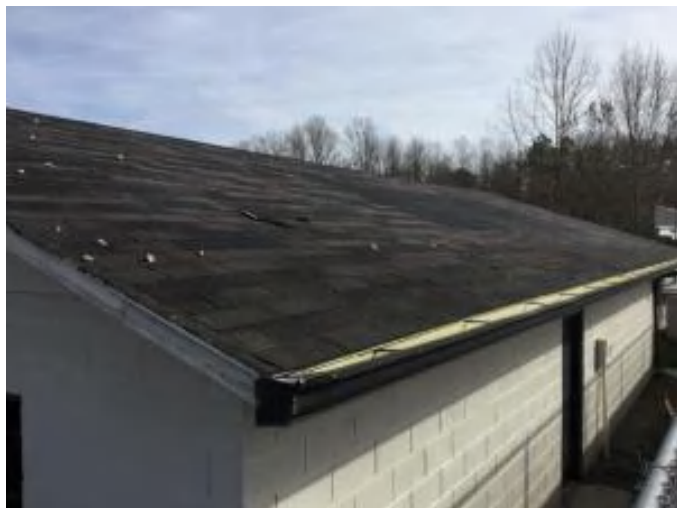
System: B3010140 - Asphalt Shingles

Location: Roof
Distress: Damaged
Category: Deferred Maintenance
Priority: 2 - Potentially Critical (Year 1)
Correction: Renew System
Qty: 1,000.00
Unit of Measure: S.F.
Estimate: \$6,307.00
Assessor Name: Eduardo Lopez
Date Created: 02/28/2017

Notes: The asphalt shingles are damaged and the covering should be replaced.
