NC School District/220 Clay County/High School

Hayesville High

Campus Assessment Report

March 7, 2017

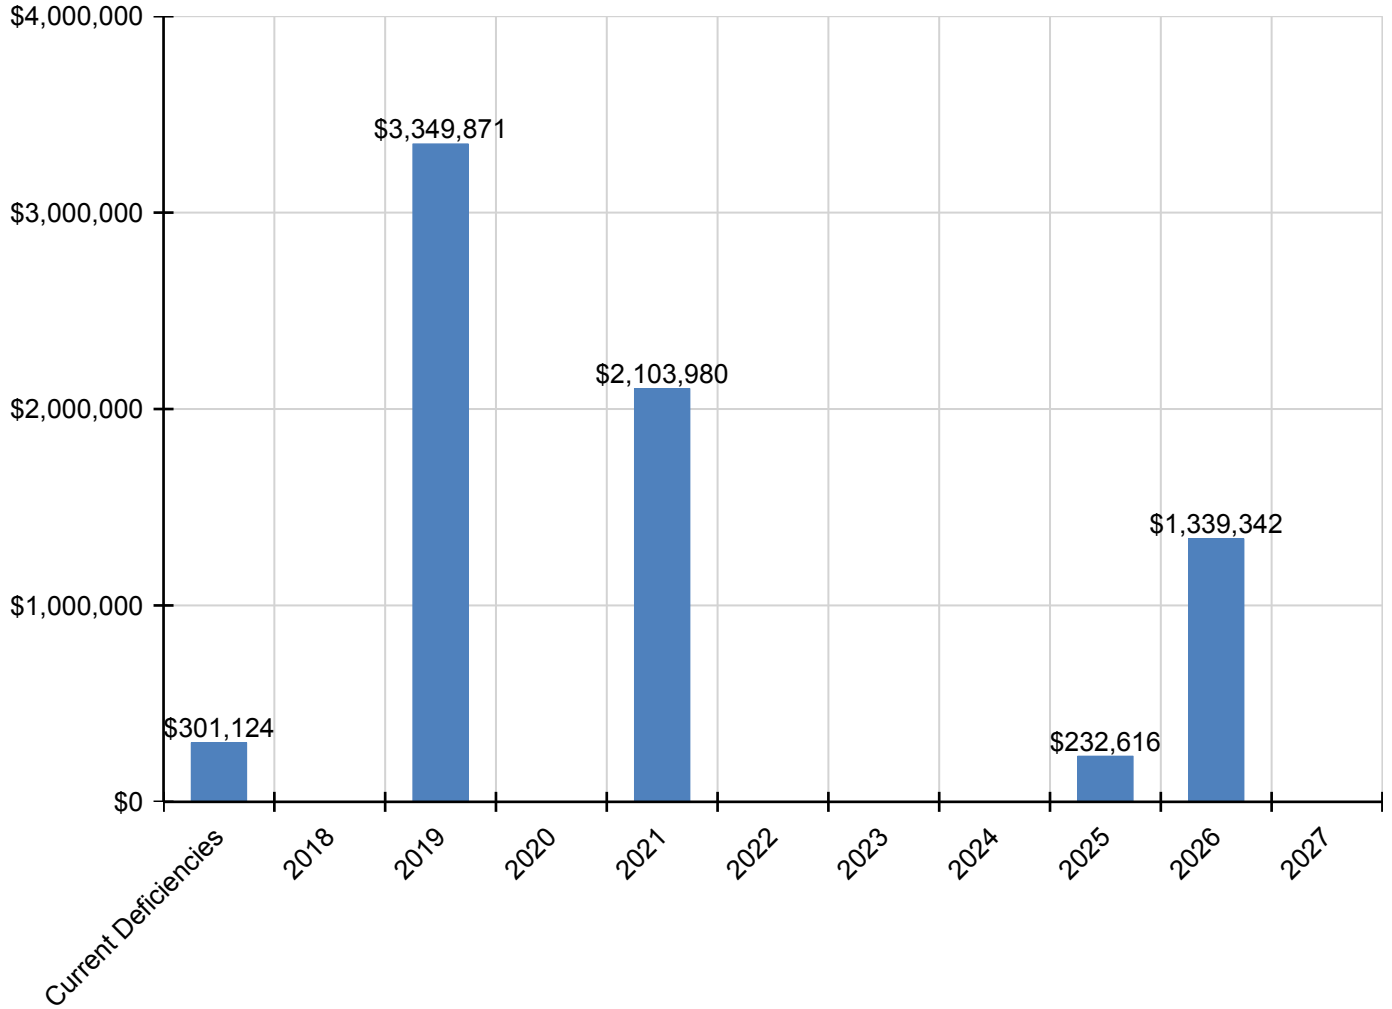
Forecasted Capital Renewal Requirement

The following chart shows the current building deficiencies and forecasting capital renewal or sustainment requirements over the next ten years.

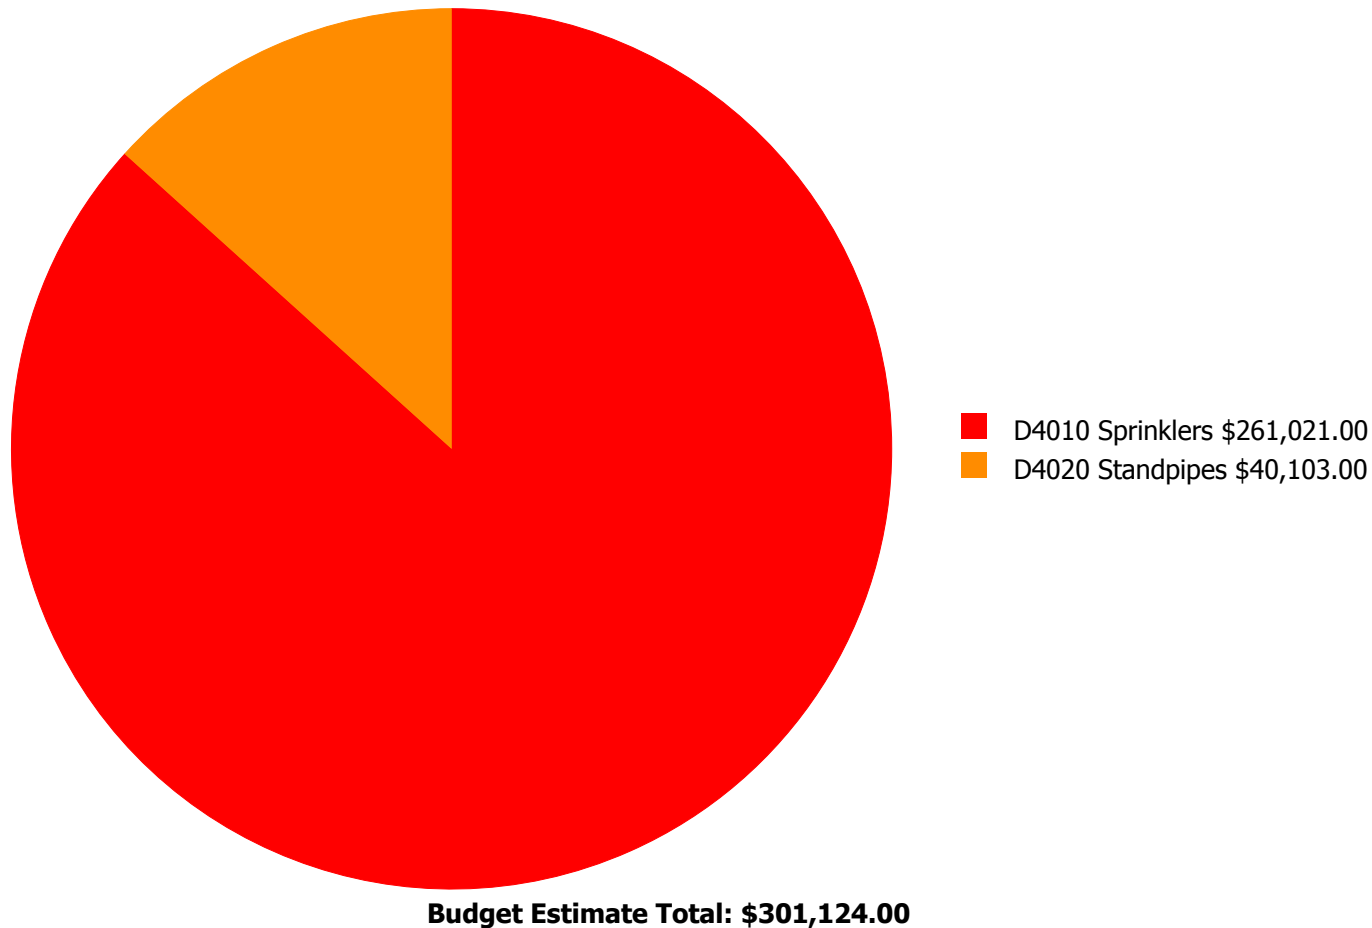
Deficiency Summary by System

Current deficiencies included assemblies that have reached or exceeded their design life or components of the assemblies that are in need of repair. Assemblies that have reached their design life are identified as current deficiencies and assigned the distress 'Beyond Useful Life'. The following chart lists all current deficiencies associated with this facility.

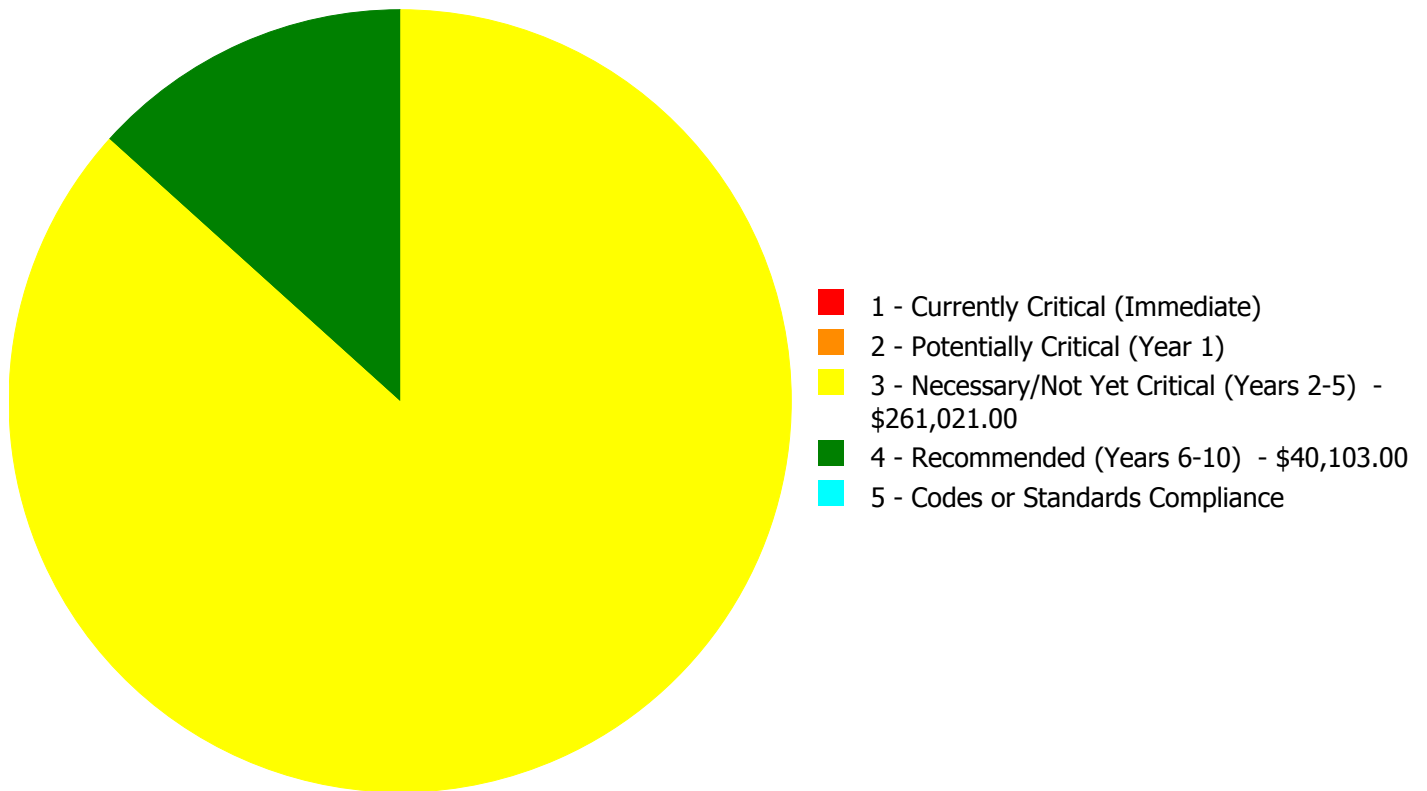
Deficiency Summary by Priority

The following chart shows the total repair costs broken down by priority. Assessors assigned deficiencies within eCOMET to one of the following priority categories:

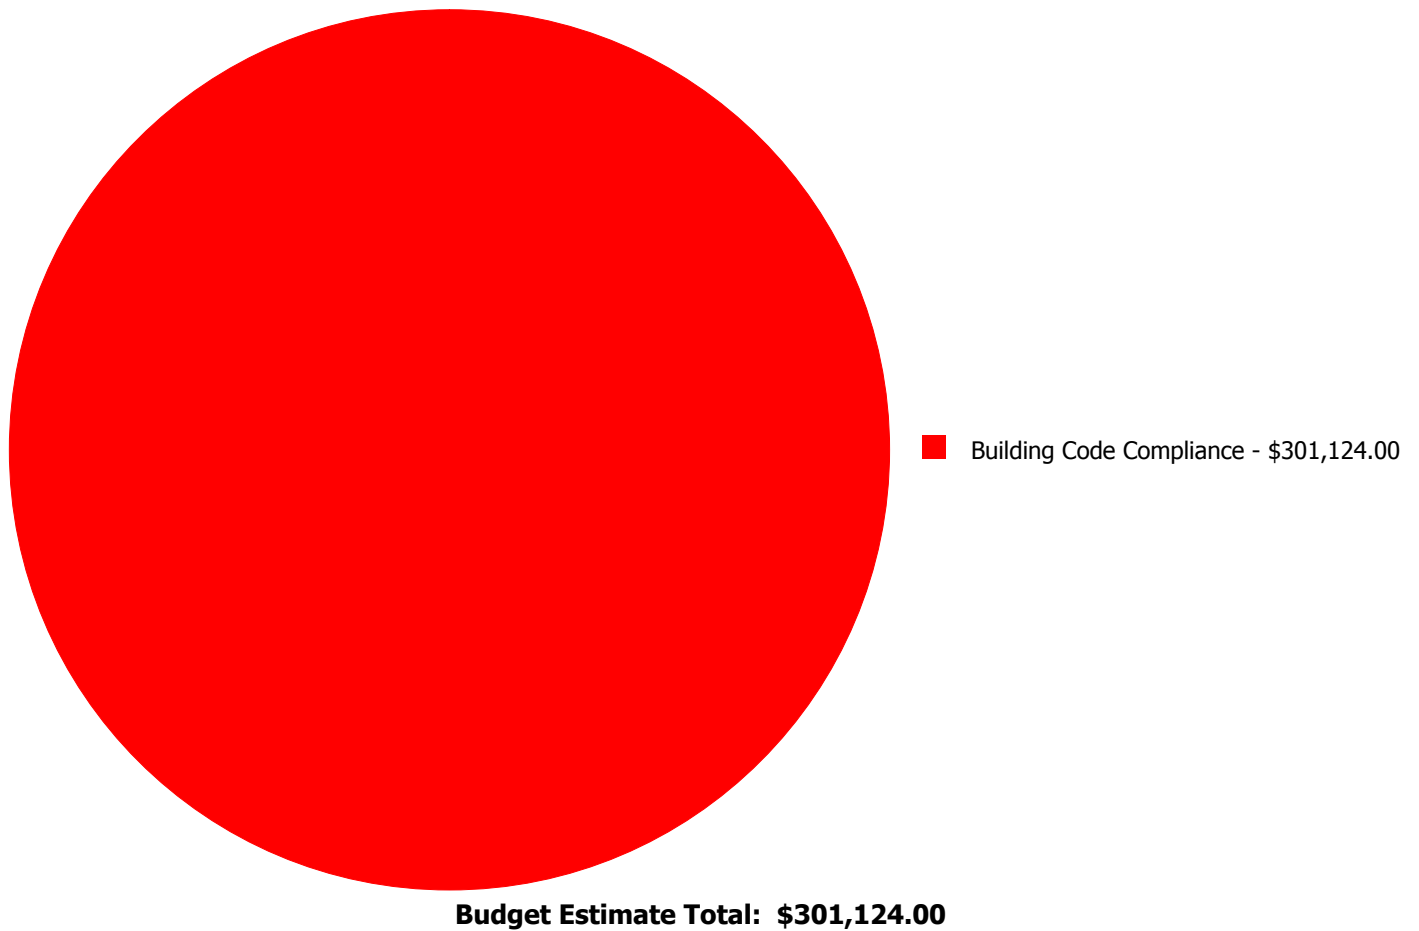
Deficiency Summary by Category

The following chart shows the total repair costs broken down by deficiency categories. Assessors assigned deficiencies to one of the following categories:

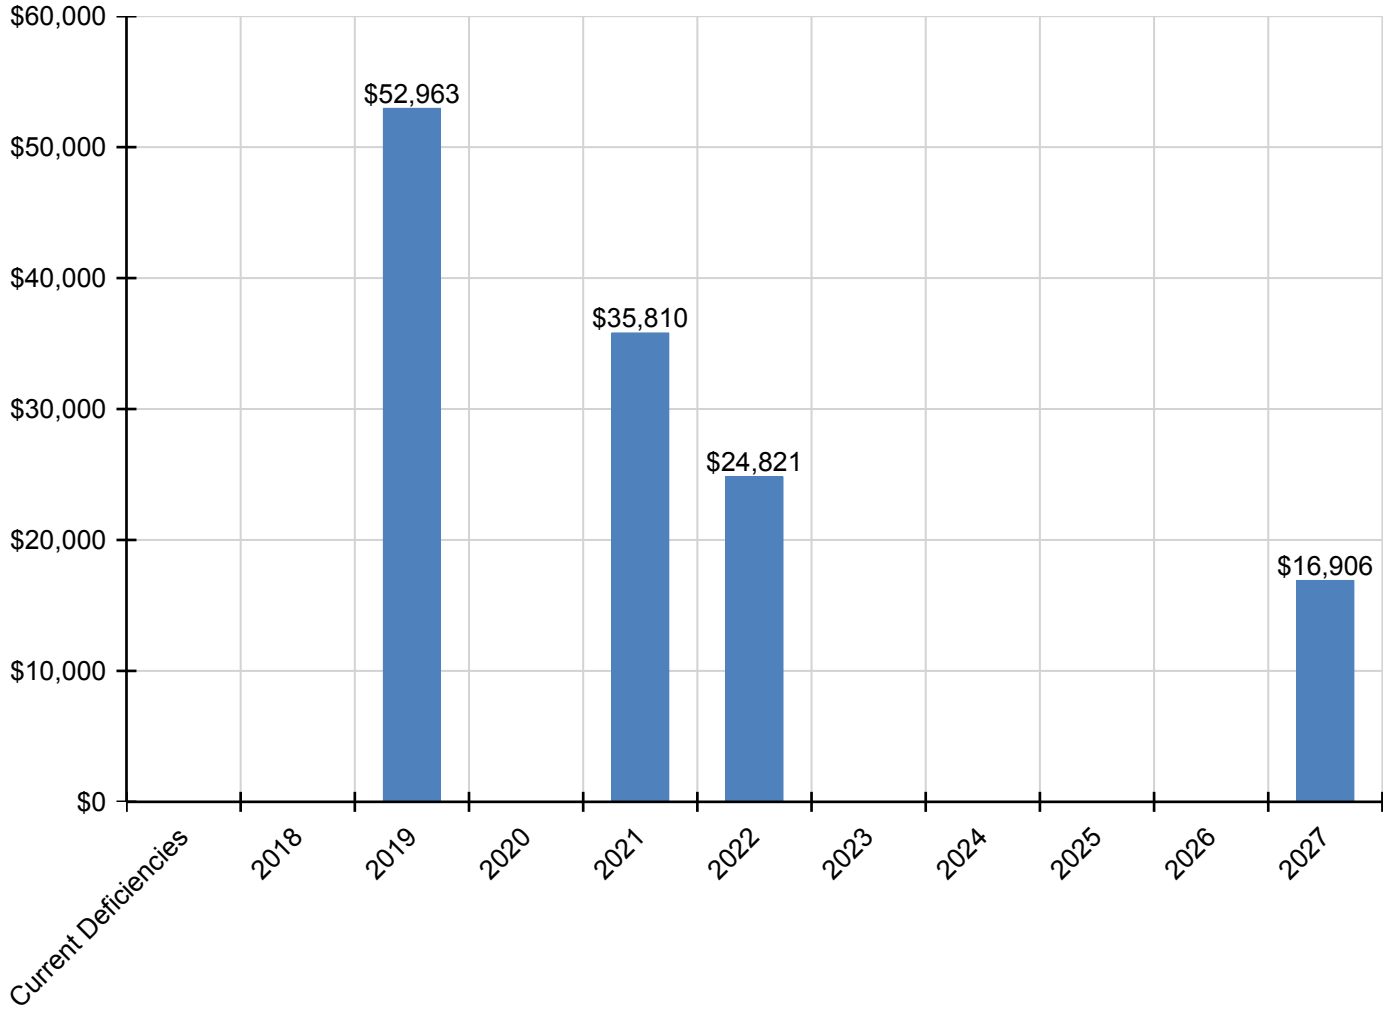
Forecasted Capital Renewal Requirement

The following chart shows the current building deficiencies and forecasting capital renewal or sustainment requirements over the next ten years.

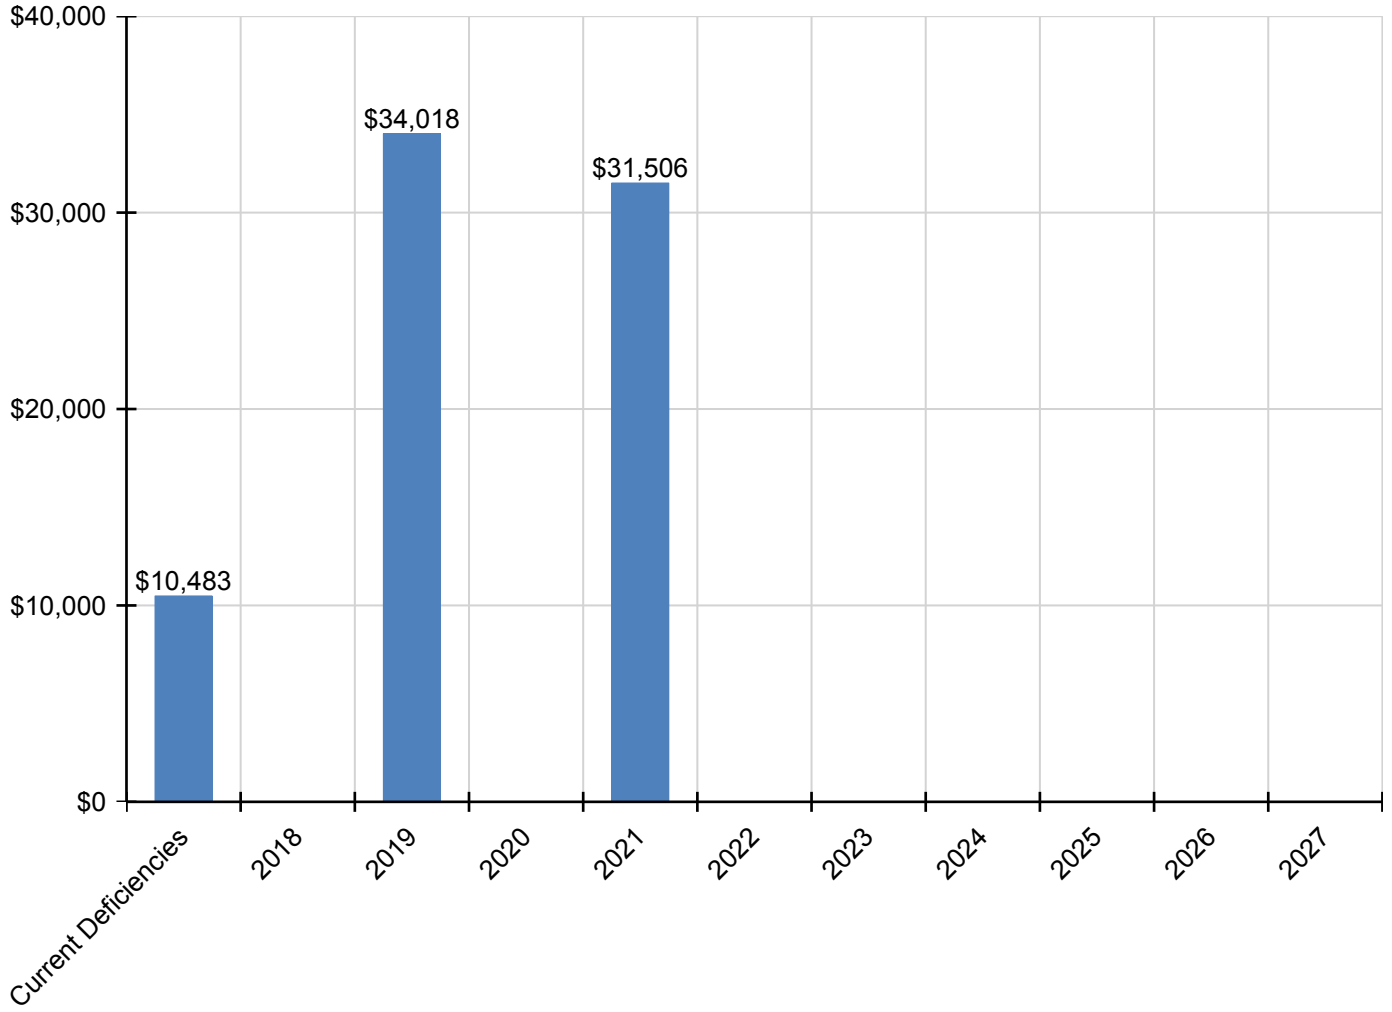
Forecasted Capital Renewal Requirement

The following chart shows the current building deficiencies and forecasting capital renewal or sustainment requirements over the next ten years.

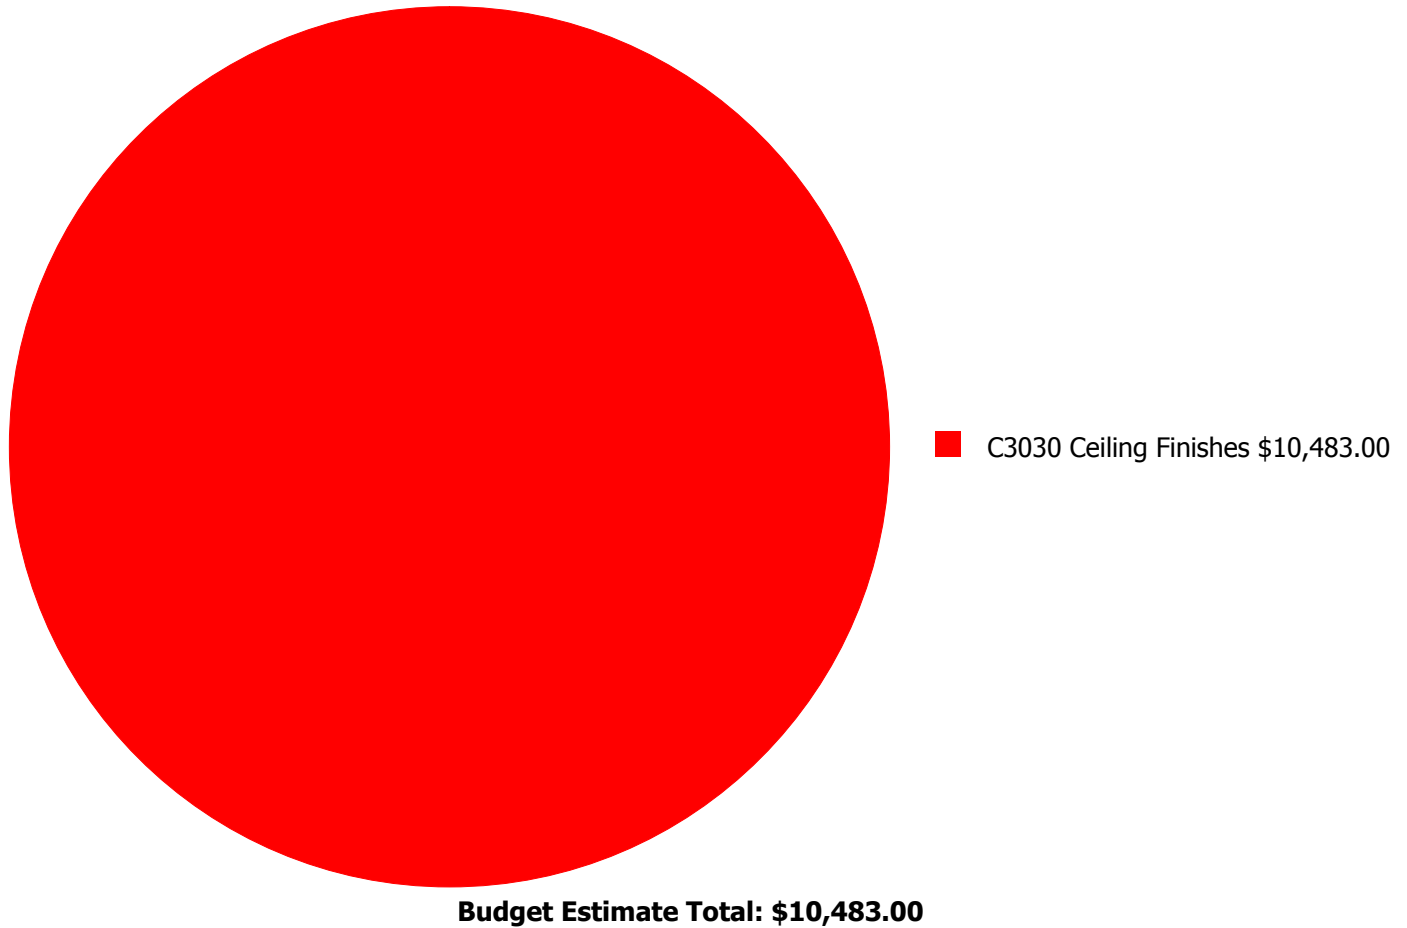
Deficiency Summary by System

Current deficiencies included assemblies that have reached or exceeded their design life or components of the assemblies that are in need of repair. Assemblies that have reached their design life are identified as current deficiencies and assigned the distress 'Beyond Useful Life'. The following chart lists all current deficiencies associated with this facility.

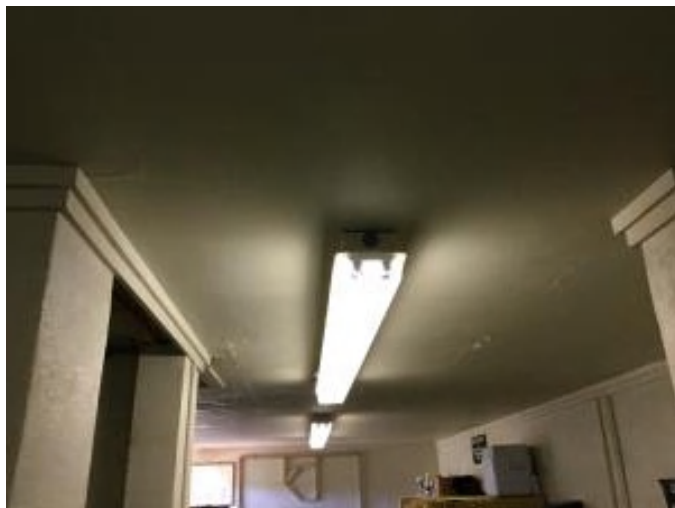
System: C3030 - Ceiling Finishes

Location: Interior
Distress: Damaged
Category: Deferred Maintenance
Priority: 3 - Necessary/Not Yet Critical (Years 2-5)
Correction: Renew System
Qty: 1,000.00
Unit of Measure: S.F.
Estimate: \$10,483.00
Assessor Name: Eduardo Lopez
Date Created: 02/14/2017

Notes: The original drywall ceiling finish is aged, chipped, stained, damaged and should be replaced.

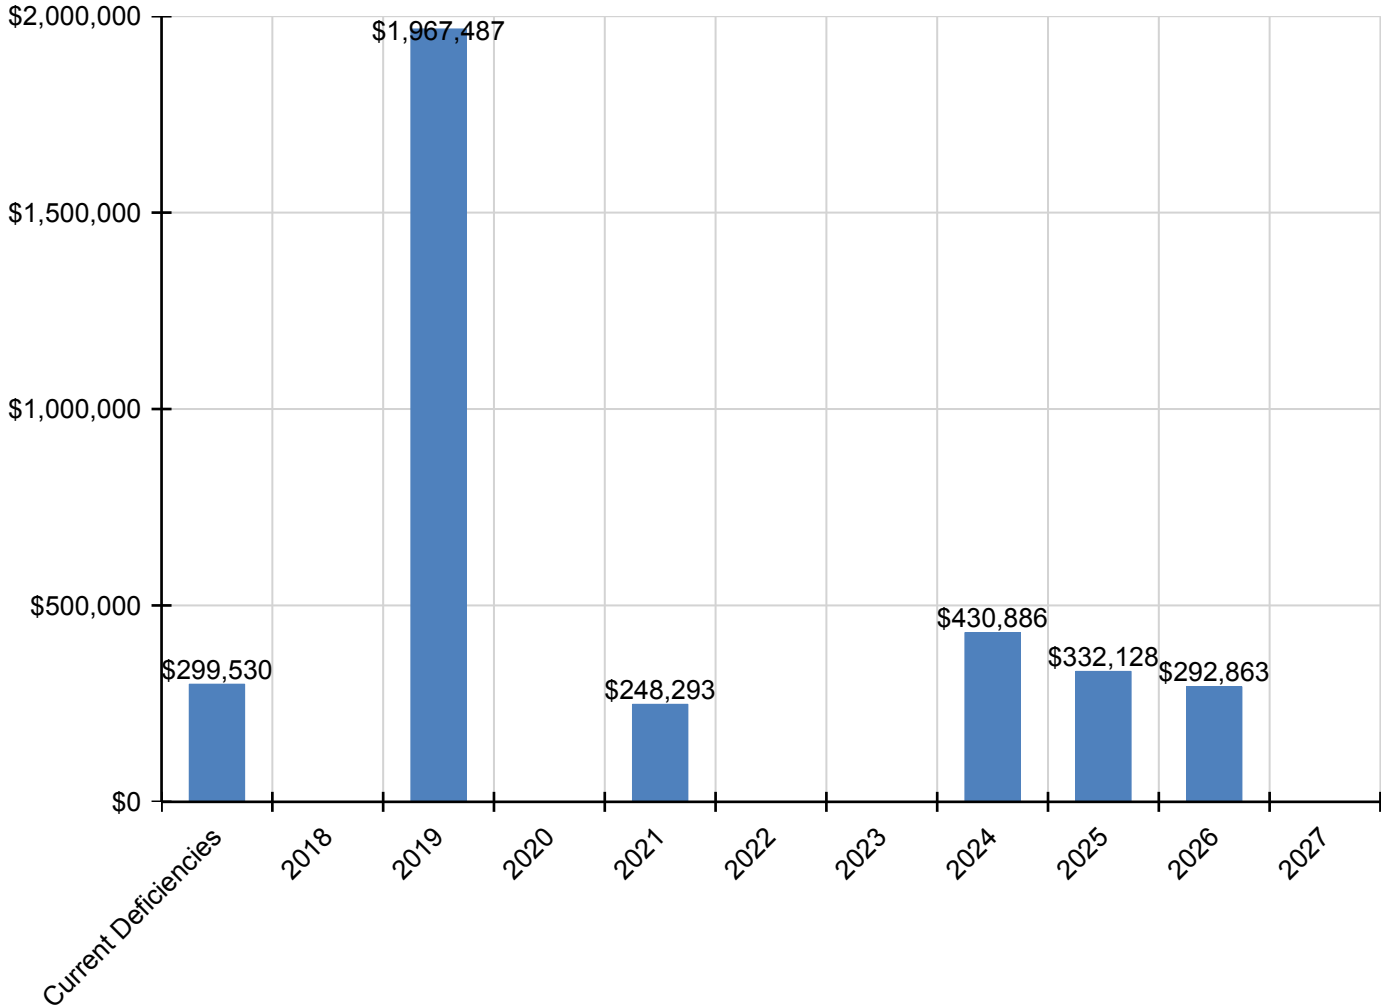
Forecasted Capital Renewal Requirement

The following chart shows the current building deficiencies and forecasting capital renewal or sustainment requirements over the next ten years.

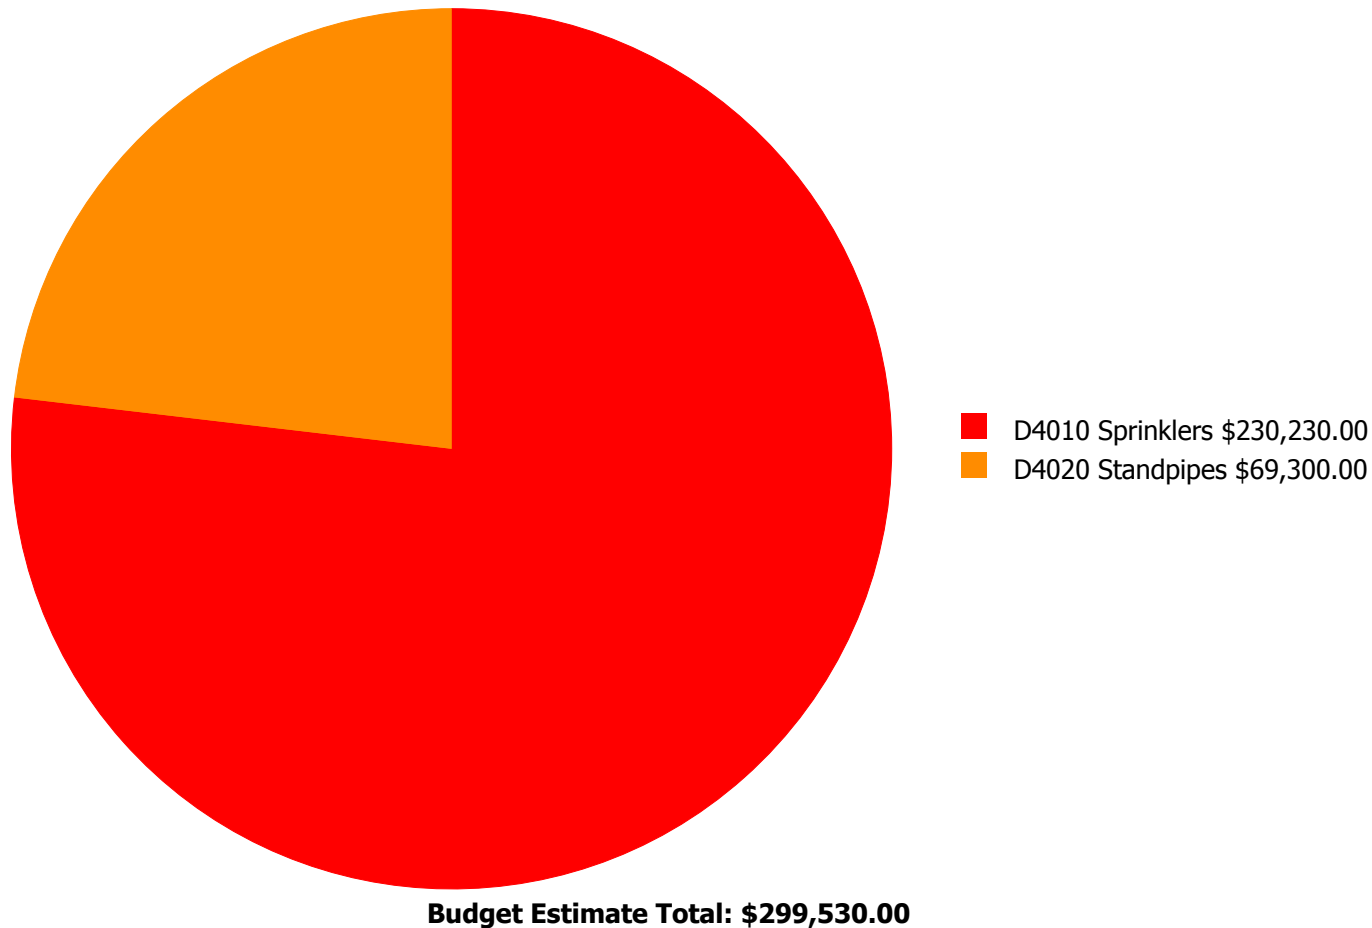
Deficiency Summary by System

Current deficiencies included assemblies that have reached or exceeded their design life or components of the assemblies that are in need of repair. Assemblies that have reached their design life are identified as current deficiencies and assigned the distress 'Beyond Useful Life'. The following chart lists all current deficiencies associated with this facility.

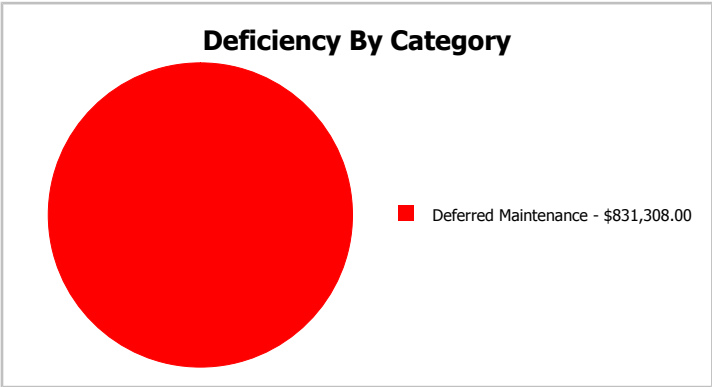
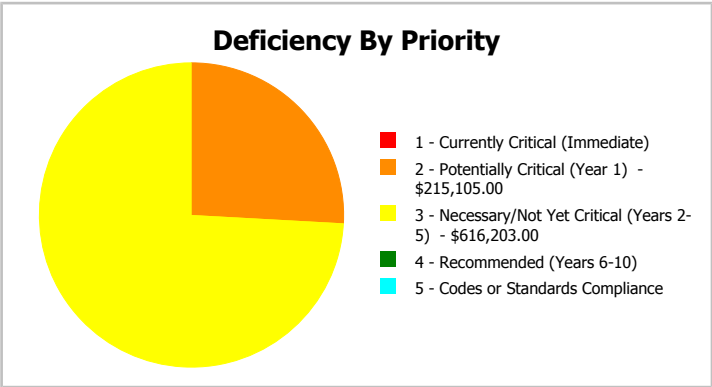
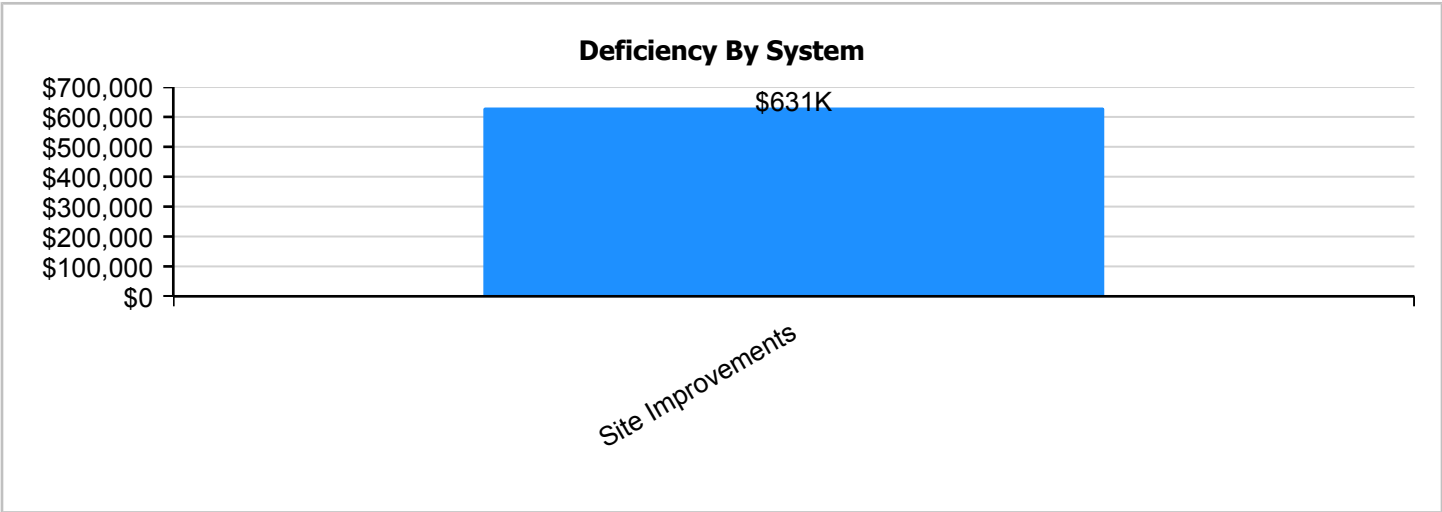
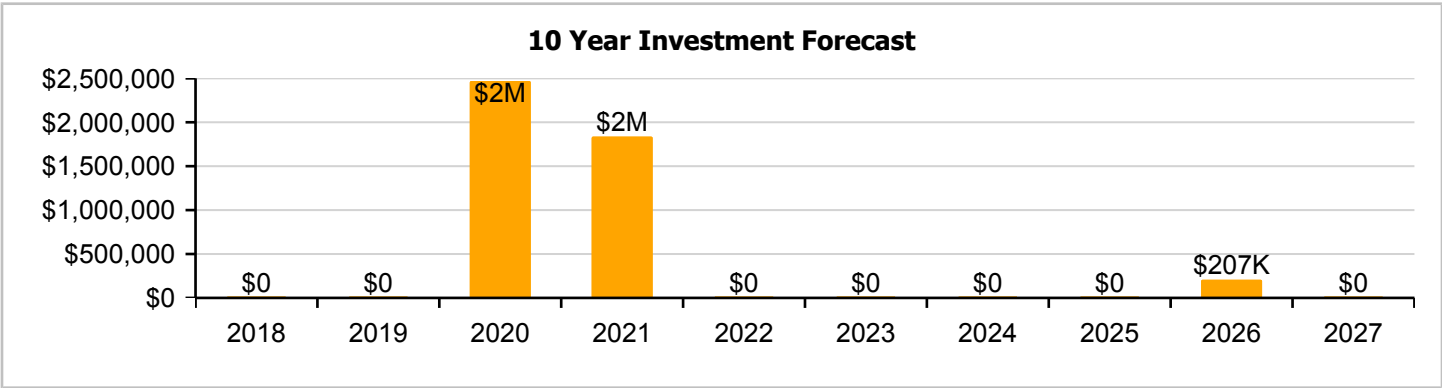
Dashboard Summary

Function:	ES -Elementary School	Gross Area:	147,030
Year Built:	1986	Last Renovation:	
Repair Cost:	\$831,308	Replacement Value:	\$6,732,504
FCI:	12.35 %	RSLI%:	22.42 %

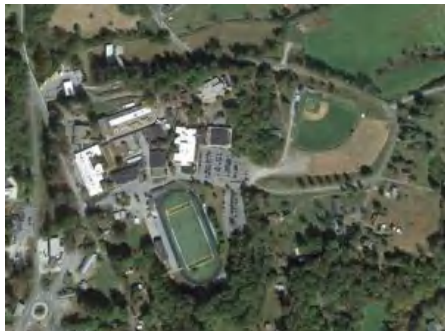
- 1). Aerial Image of Hayesville Schools - Feb 24, 2017

The photo album consists of the various cardinal directions of the building..

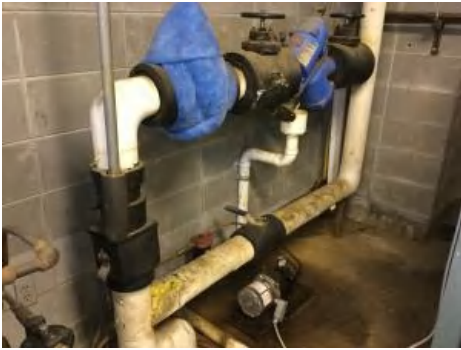
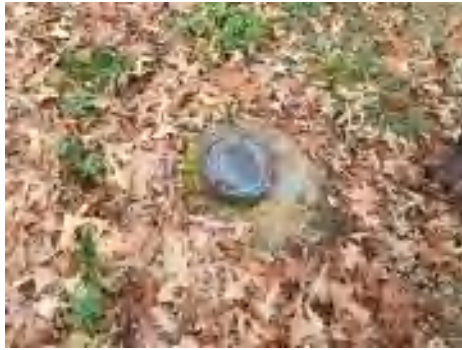
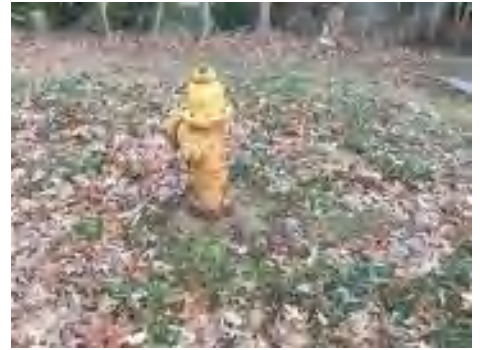
System: G3010 - Water Supply

Note: Supplies elementary, middle and high school

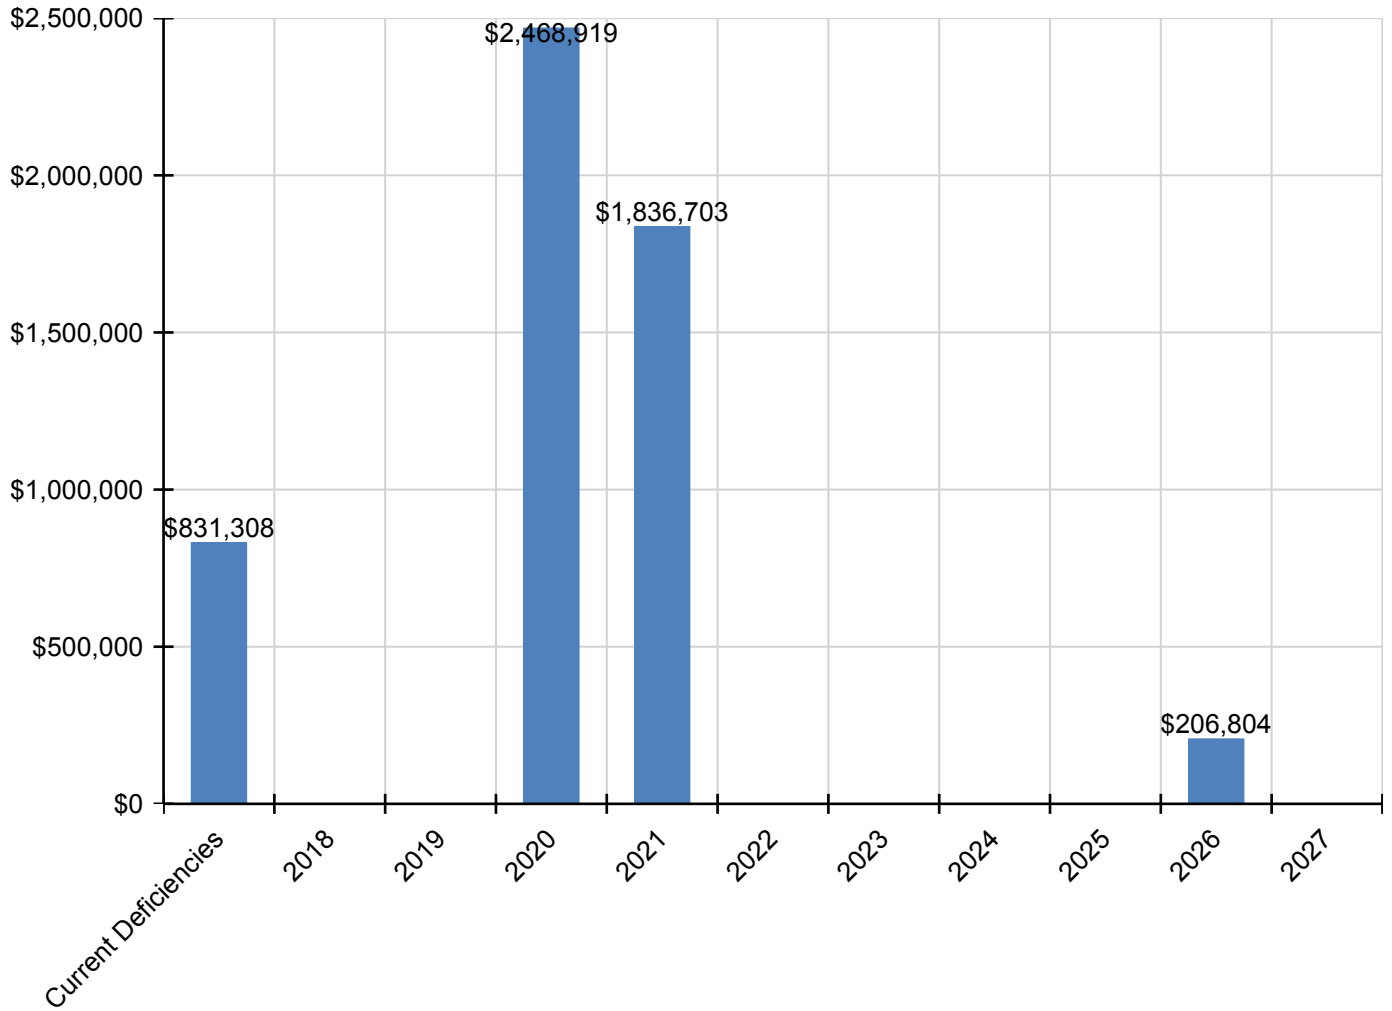
Forecasted Capital Renewal Requirement

The following chart shows the current building deficiencies and forecasting capital renewal or sustainment requirements over the next ten years.

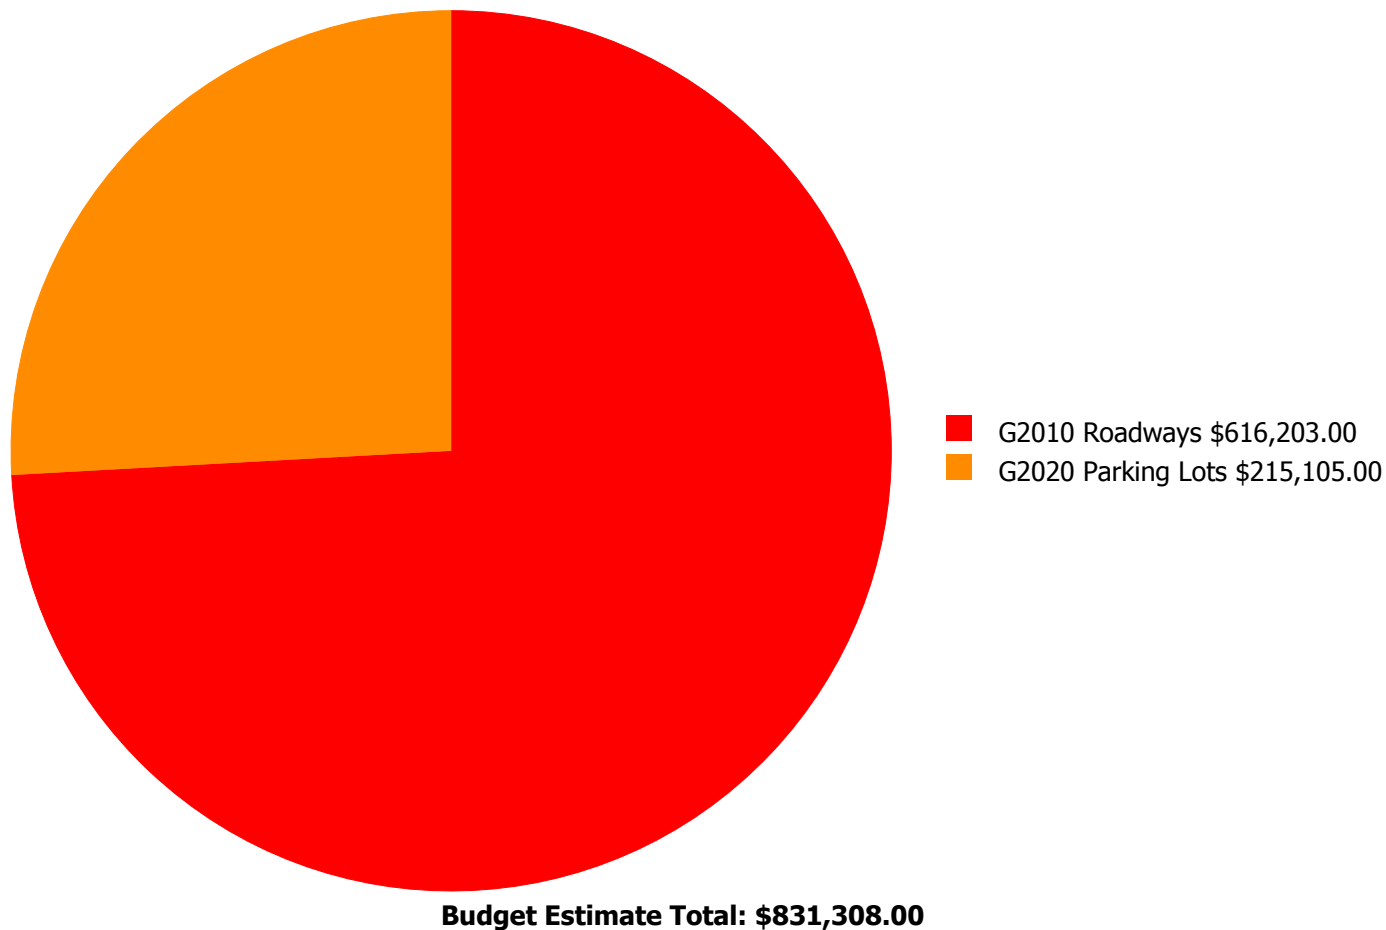
Deficiency Summary by System

Current deficiencies included assemblies that have reached or exceeded their design life or components of the assemblies that are in need of repair. Assemblies that have reached their design life are identified as current deficiencies and assigned the distress 'Beyond Useful Life'. The following chart lists all current deficiencies associated with this facility.

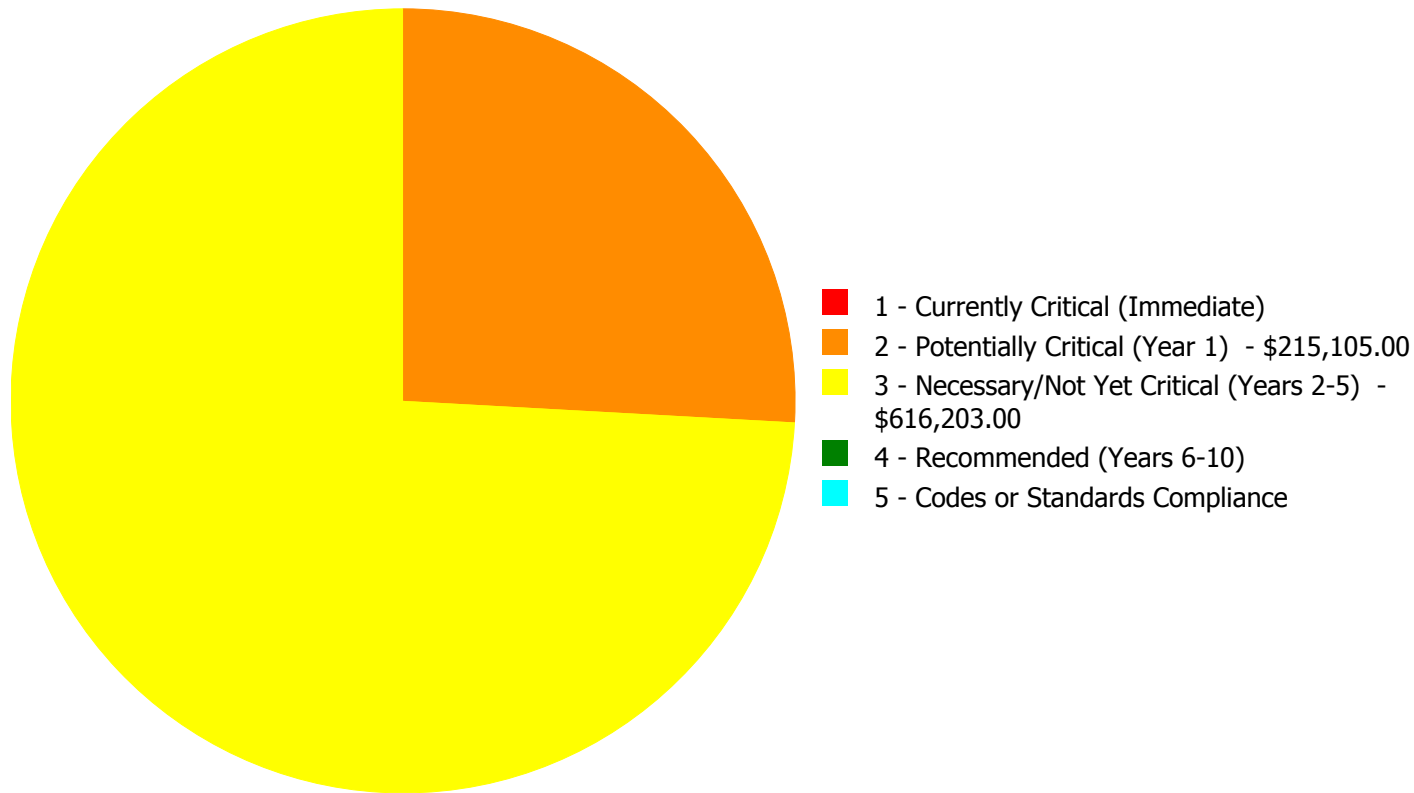
Deficiency Summary by Priority

The following chart shows the total repair costs broken down by priority. Assessors assigned deficiencies within eCOMET to one of the following priority categories:

Budget Estimate Total: \$831,308.00

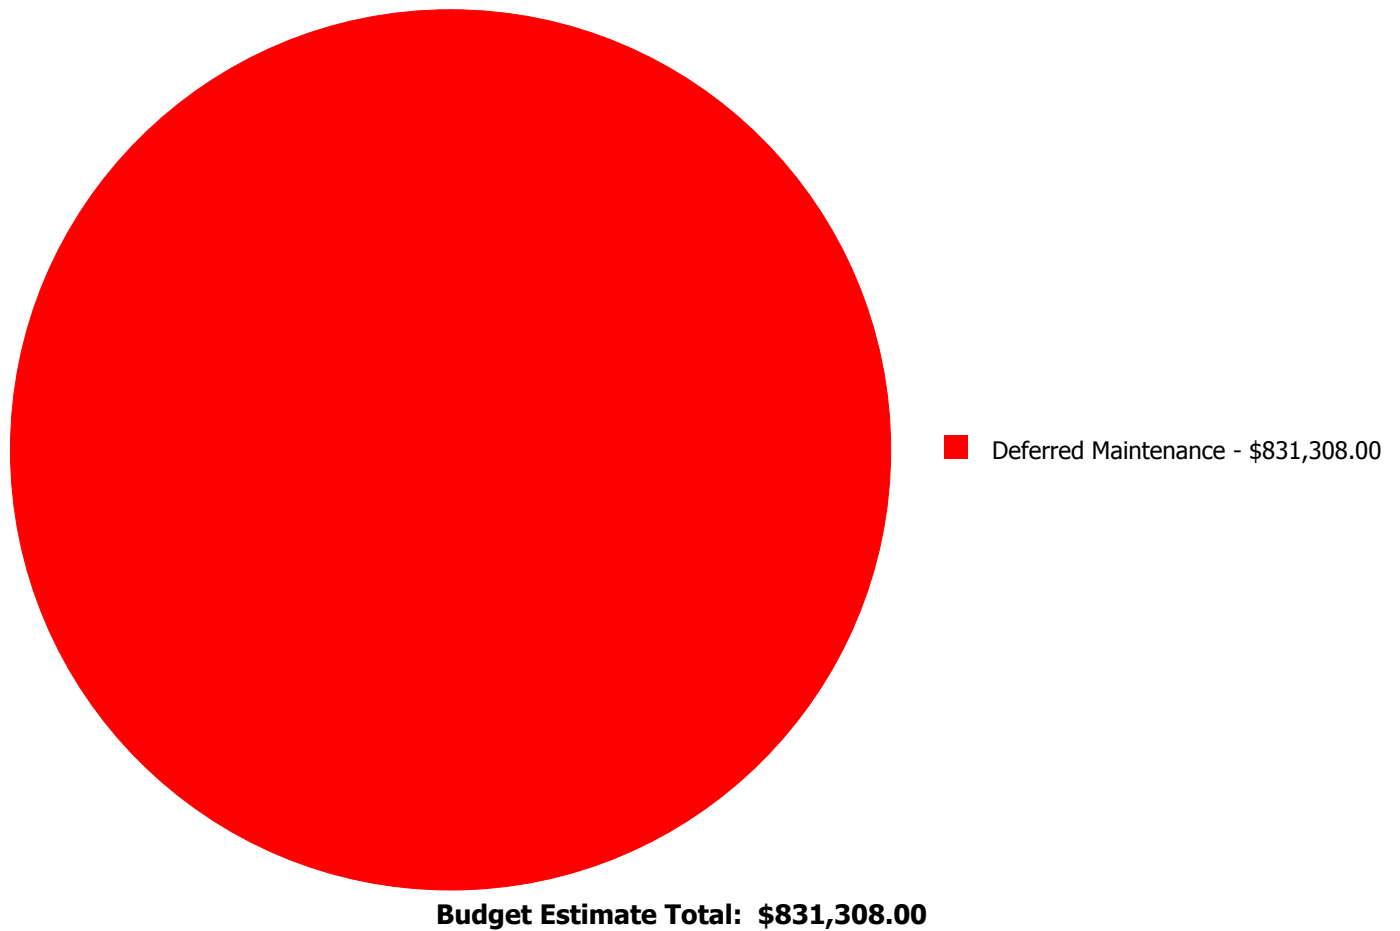
Deficiency Summary by Category

The following chart shows the total repair costs broken down by deficiency categories. Assessors assigned deficiencies to one of the following categories:

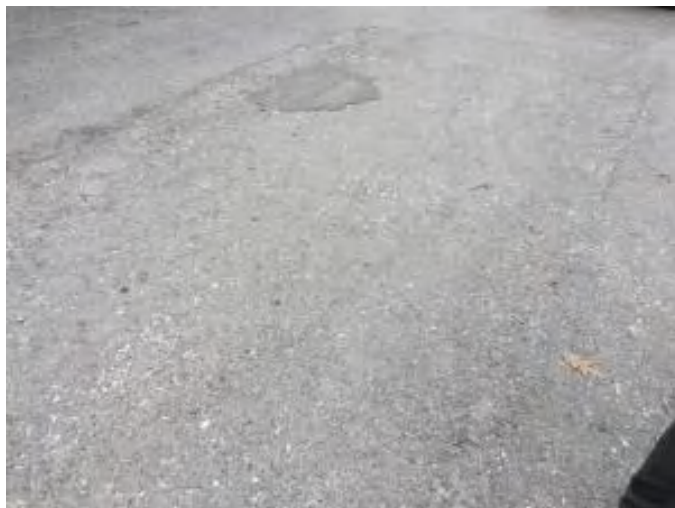
System: G2020 - Parking Lots

Location: Site
Distress: Damaged
Category: Deferred Maintenance
Priority: 2 - Potentially Critical (Year 1)
Correction: Renew System
Qty: 147,030.00
Unit of Measure: S.F.
Estimate: \$215,105.00
Assessor Name: Eduardo Lopez
Date Created: 02/09/2017

Notes: The Parking lots are aged, have many road cuts, pot holes, significant cracking, and need re-surfacing and restriping to meet all ADA guidelines to include signage and fire markings.

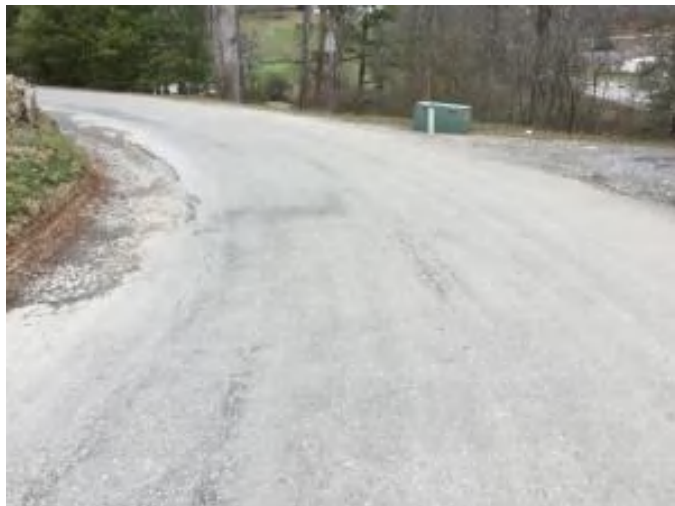
System: G2010 - Roadways

Location: Site
Distress: Damaged
Category: Deferred Maintenance
Priority: 3 - Necessary/Not Yet Critical (Years 2-5)
Correction: Renew System
Qty: 147,030.00
Unit of Measure: S.F.
Estimate: \$616,203.00
Assessor Name: Eduardo Lopez
Date Created: 02/09/2017

Notes: The asphaltic roadways are aged, have many road cuts, pot holes, significant cracking, and need re-surfacing.

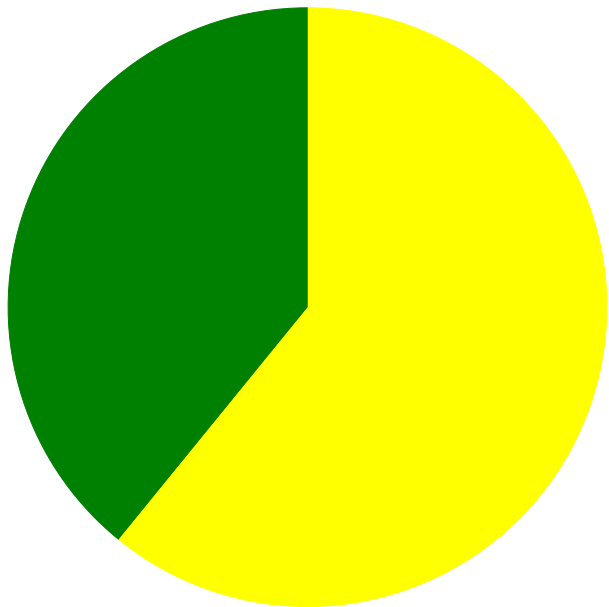
Deficiencies By Priority

- 1 - Currently Critical (Immediate)
- 2 - Potentially Critical (Year 1)
- 3 - Necessary/Not Yet Critical (Years 2-5) - \$254,074.00
- 4 - Recommended (Years 6-10) - \$163,295.00
- 5 - Codes or Standards Compliance

Budget Estimate Total: \$417,369.00

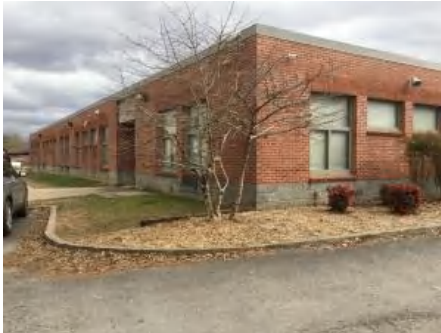
1). North Elevation - Feb 09, 2017

The photo album consists of the various cardinal directions of the building..

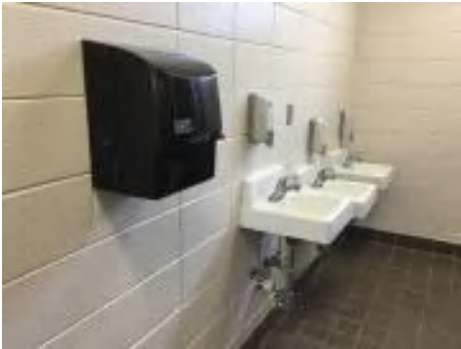
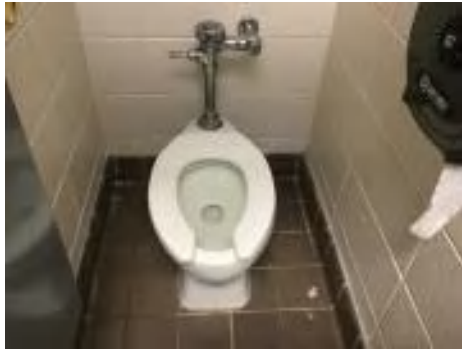
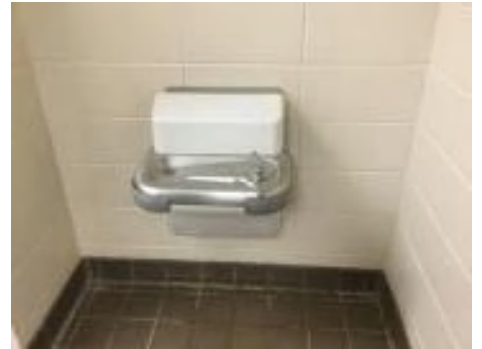
System: D2010 - Plumbing Fixtures
