NC School District/220 Clay County/High School

Hayesville High

Campus Assessment Report

March 7, 2017

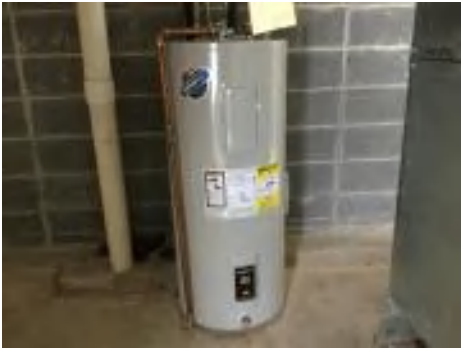
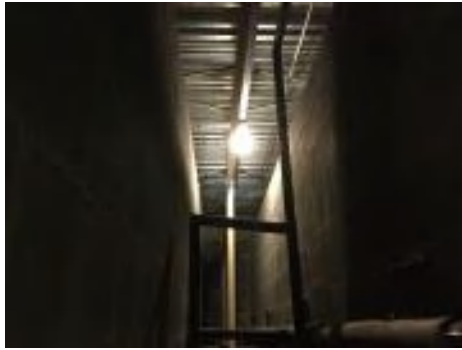
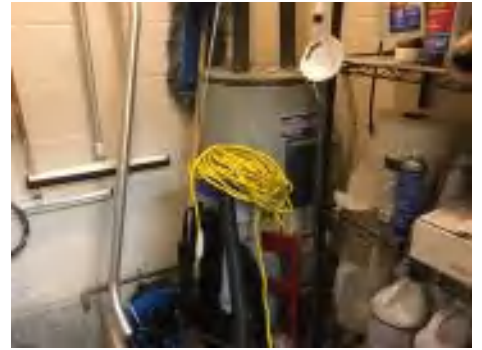
System: D2020 - Domestic Water Distribution

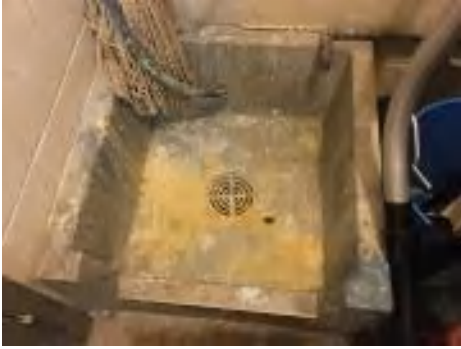
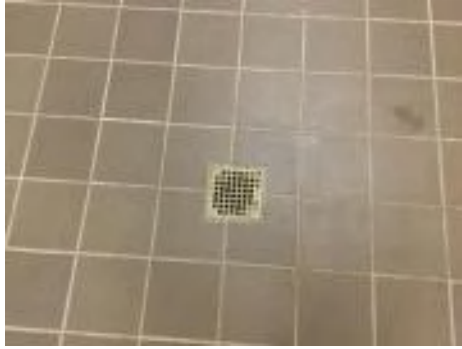
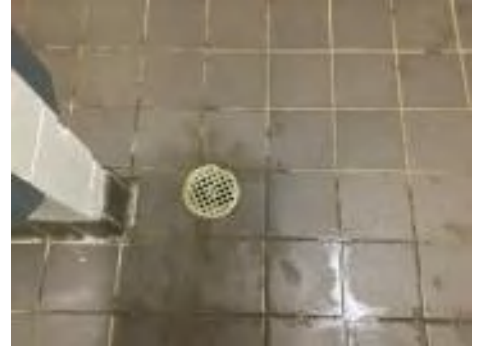
System: D2030 - Sanitary Waste

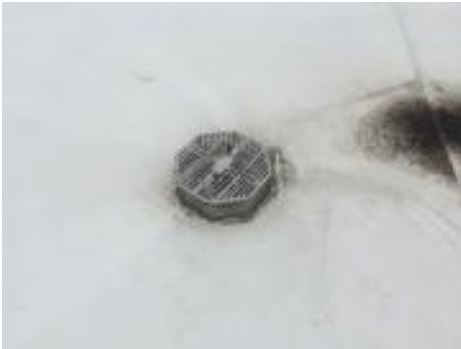
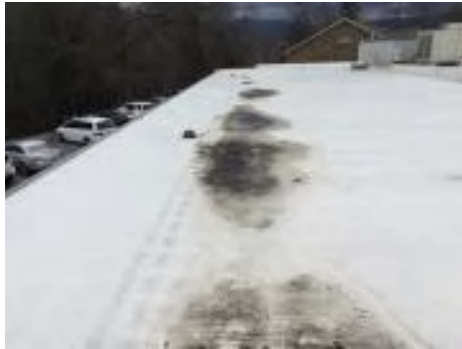
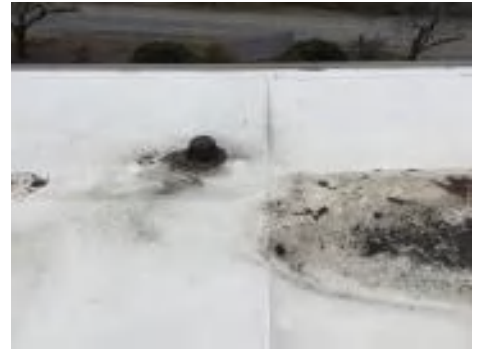
System: D2040 - Rain Water Drainage

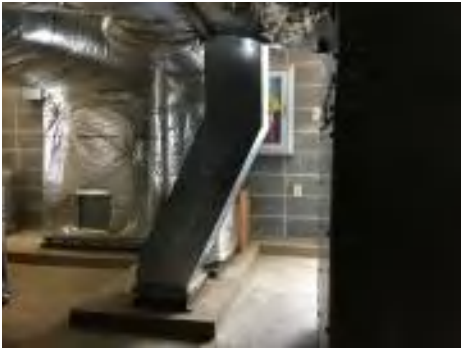
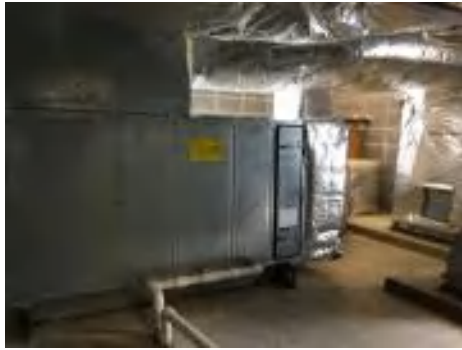
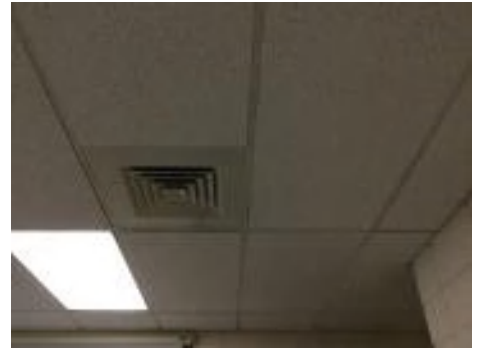
System: D3040 - Distribution Systems

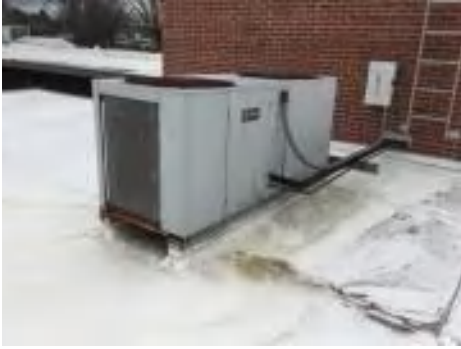
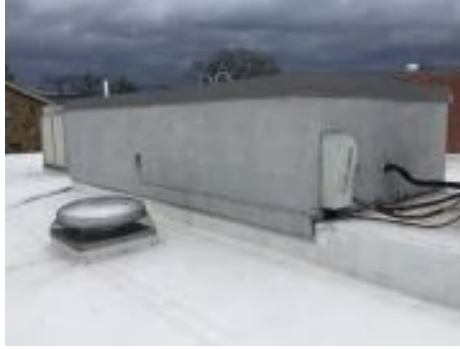
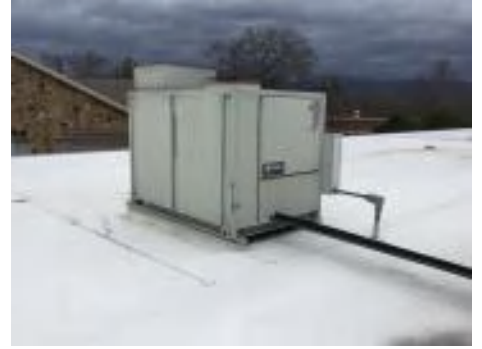
System: D3050 - Terminal & Package Units

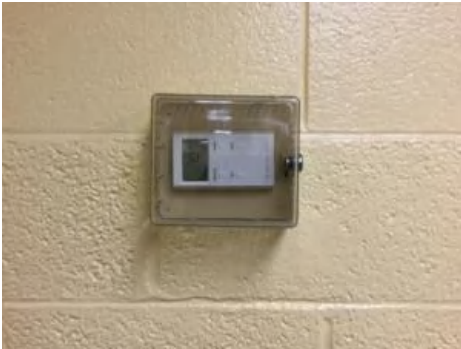
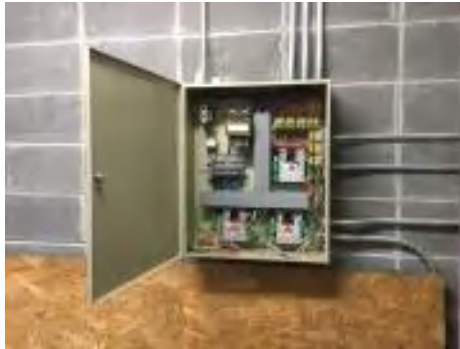
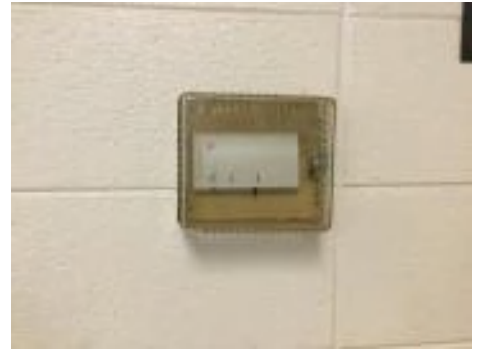
System: D3060 - Controls & Instrumentation

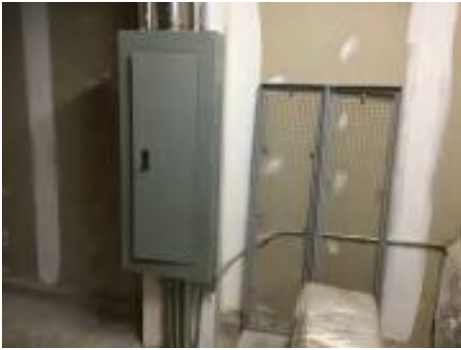
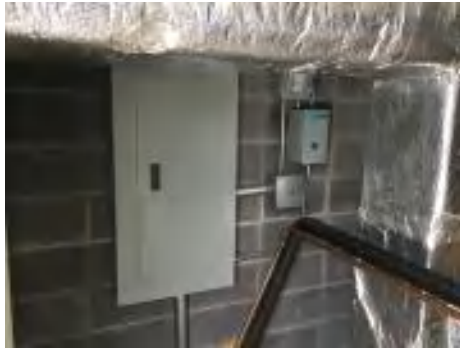
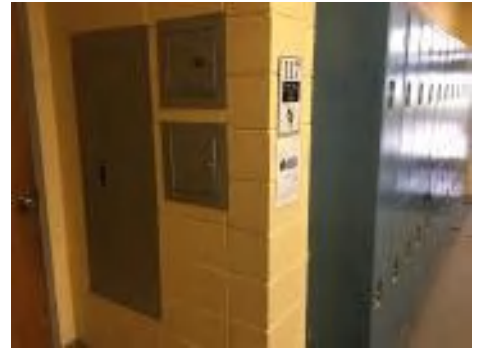
System: D5010 - Electrical Service/Distribution

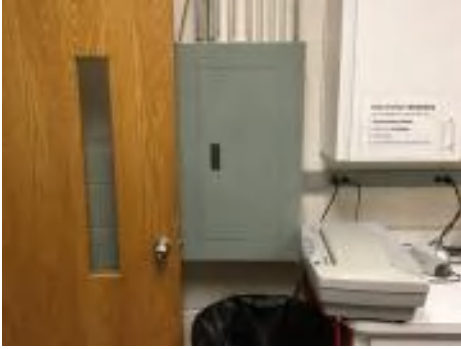
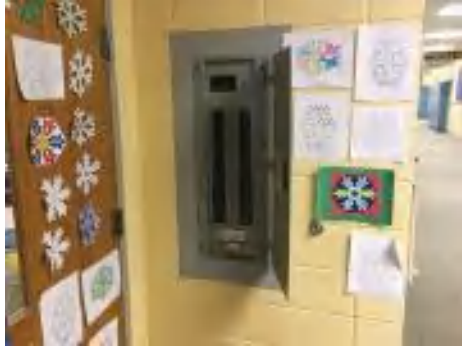
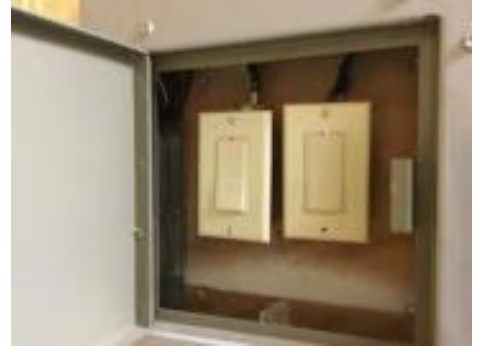
System: D5020 - Branch Wiring

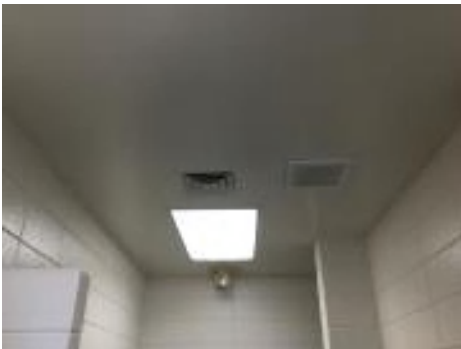
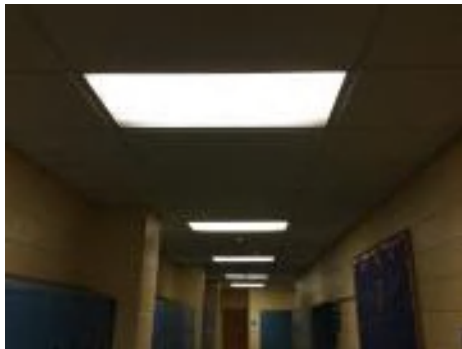
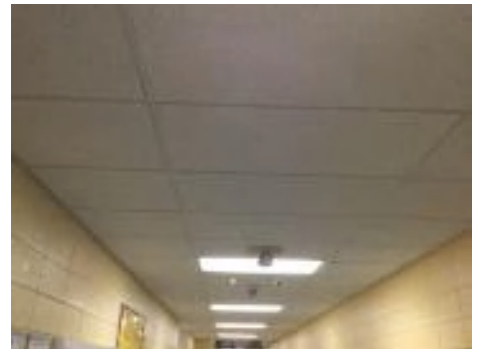
System: D5020 - Lighting

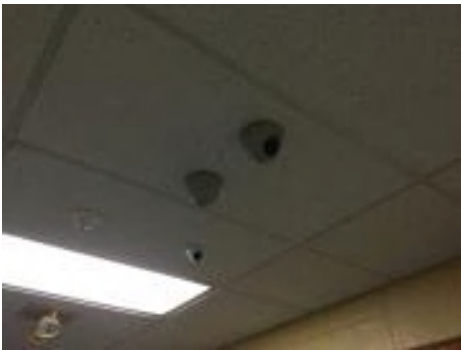
System: D5030810 - Security & Detection Systems

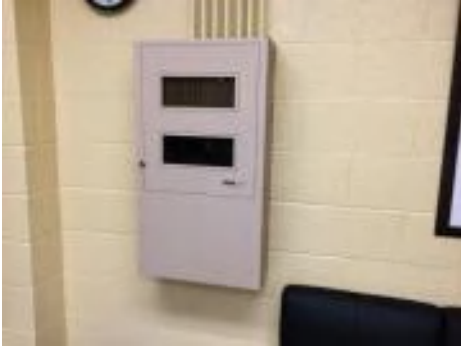
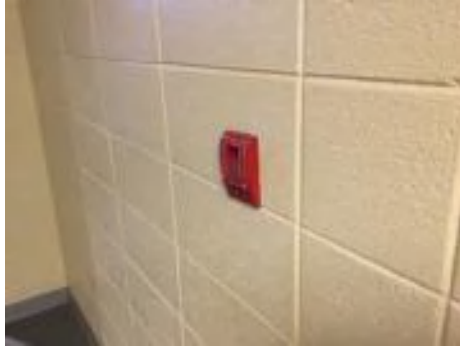
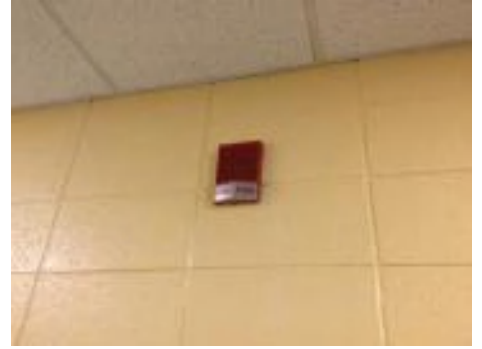
System: D5030910 - Fire Alarm Systems

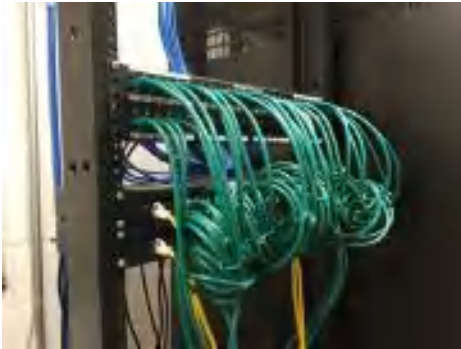
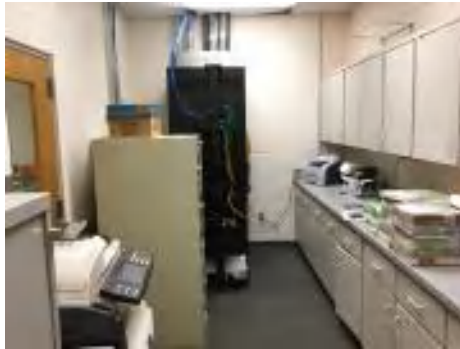
System: D5030920 - Data Communication

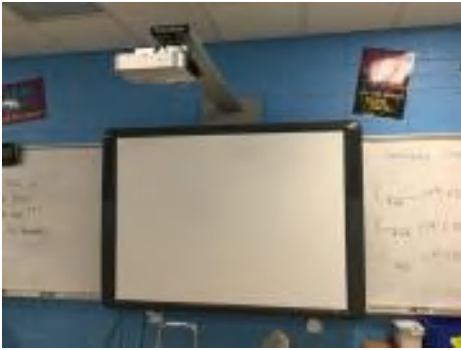
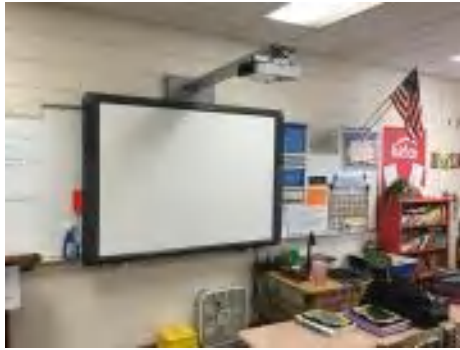
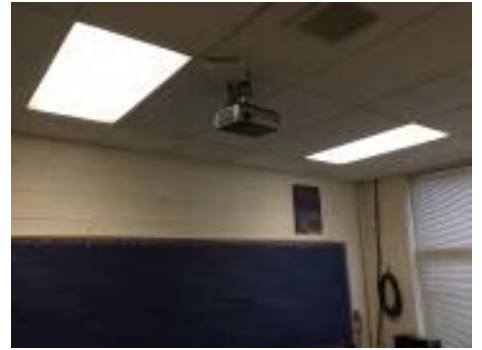
System: E1020 - Institutional Equipment

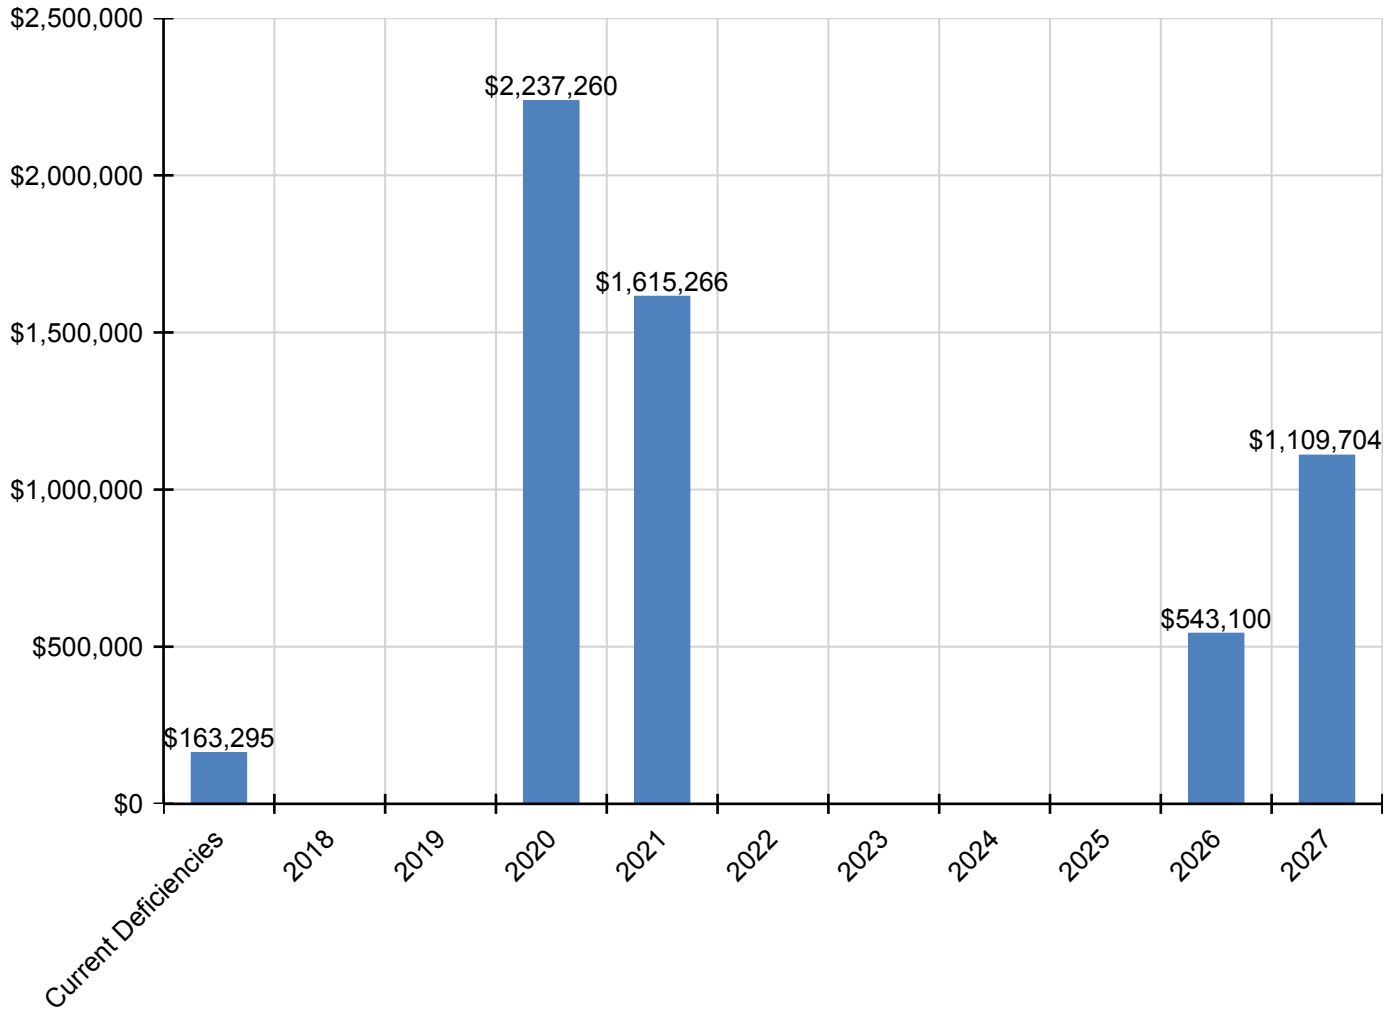
Forecasted Capital Renewal Requirement

The following chart shows the current building deficiencies and forecasting capital renewal or sustainment requirements over the next ten years.

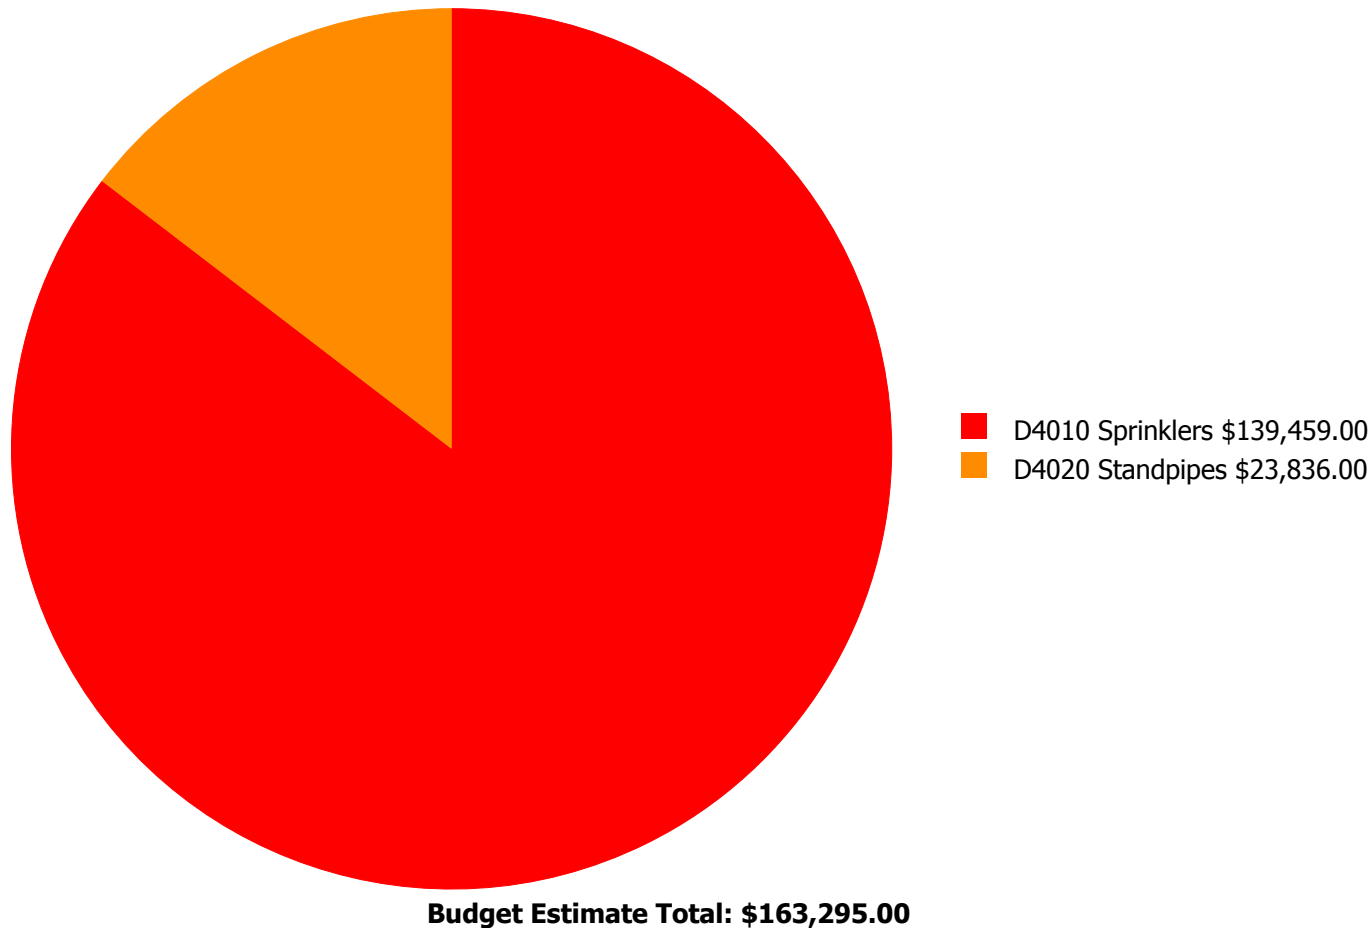
Deficiency Summary by System

Current deficiencies included assemblies that have reached or exceeded their design life or components of the assemblies that are in need of repair. Assemblies that have reached their design life are identified as current deficiencies and assigned the distress 'Beyond Useful Life'. The following chart lists all current deficiencies associated with this facility.

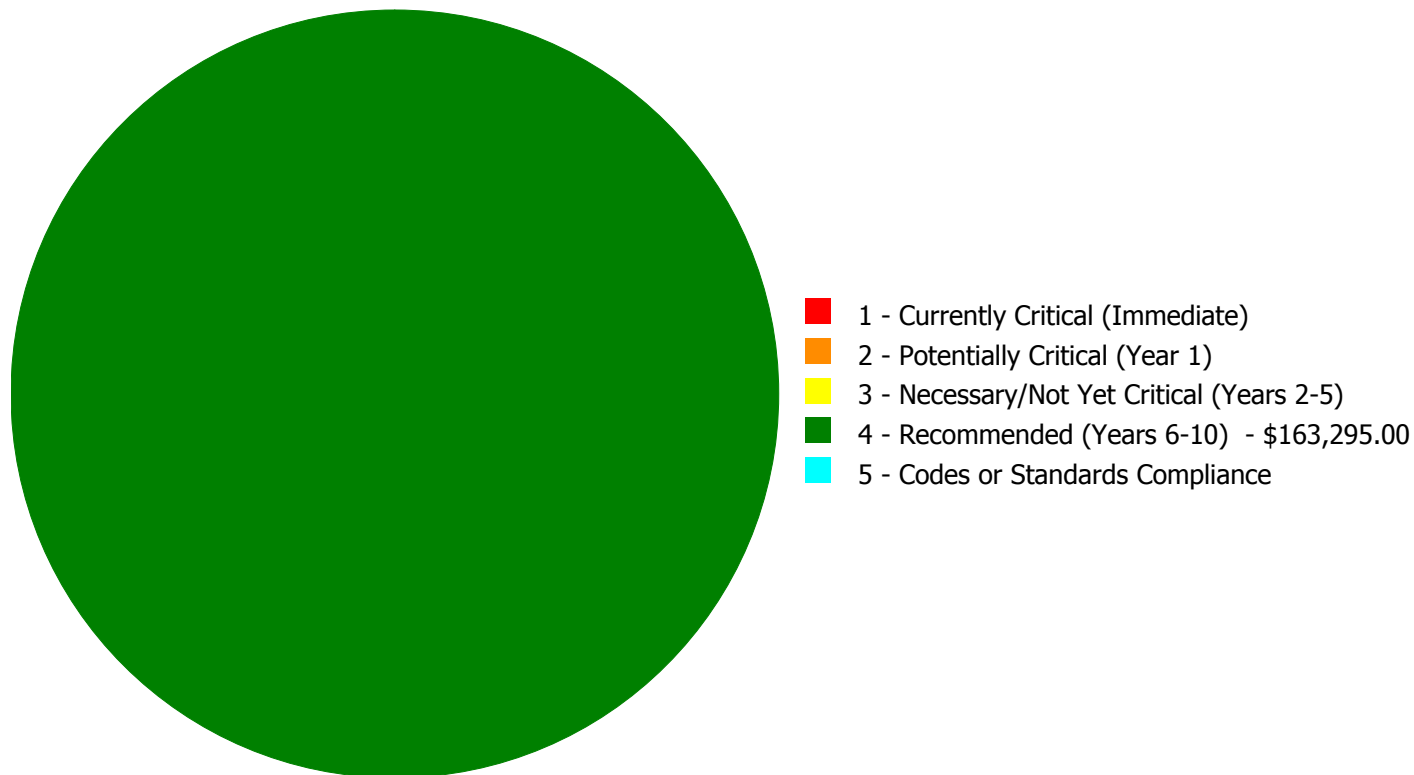
Deficiency Summary by Priority

The following chart shows the total repair costs broken down by priority. Assessors assigned deficiencies within eCOMET to one of the following priority categories:

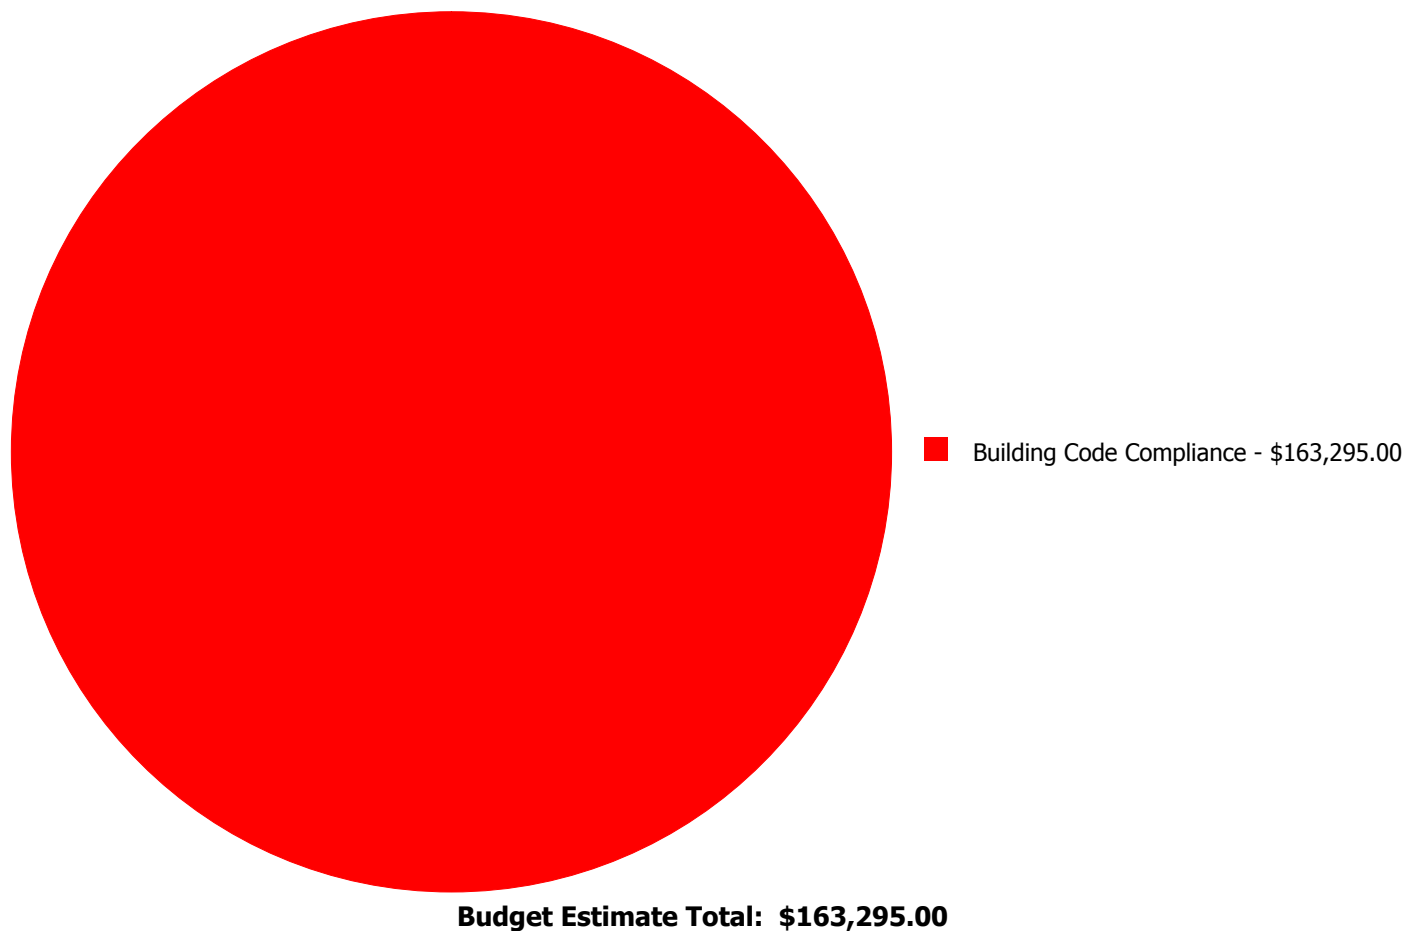
Deficiency Summary by Category

The following chart shows the total repair costs broken down by deficiency categories. Assessors assigned deficiencies to one of the following categories:

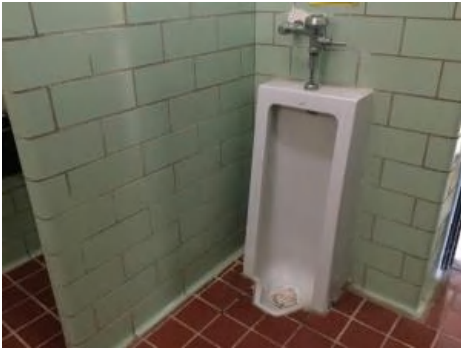
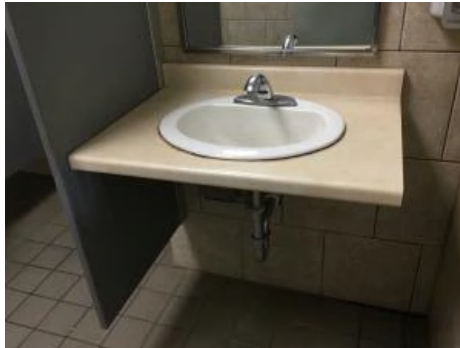
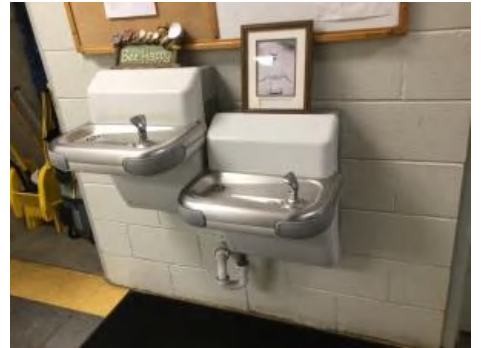
System: D2010 - Plumbing Fixtures

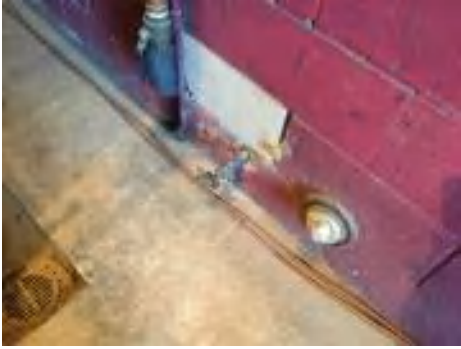
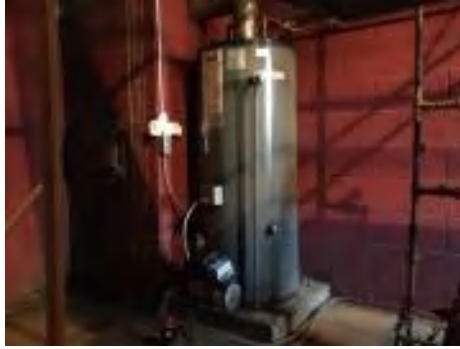
System: D2020 - Domestic Water Distribution

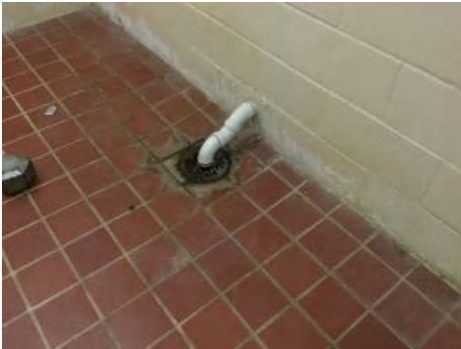
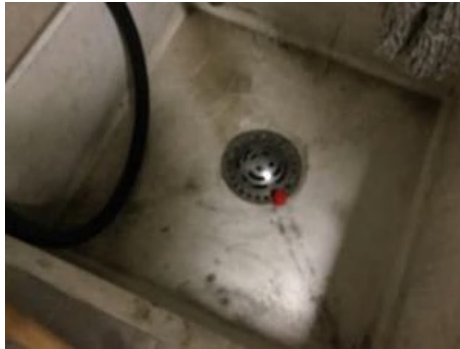
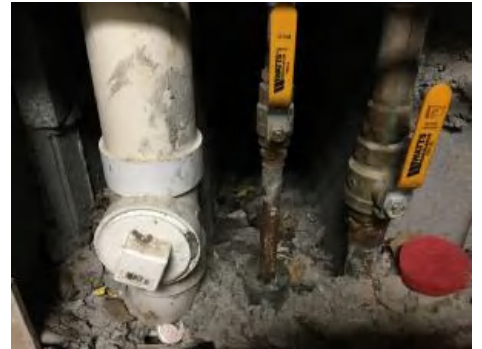
System: D2030 - Sanitary Waste

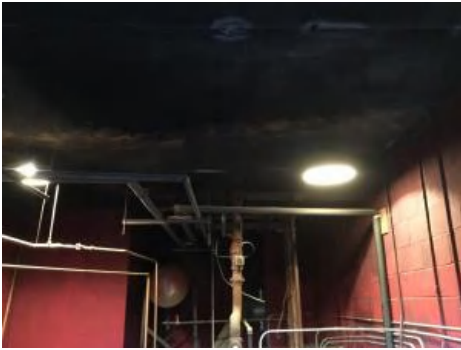
System: D2090 - Other Plumbing Systems - No 2 Oil

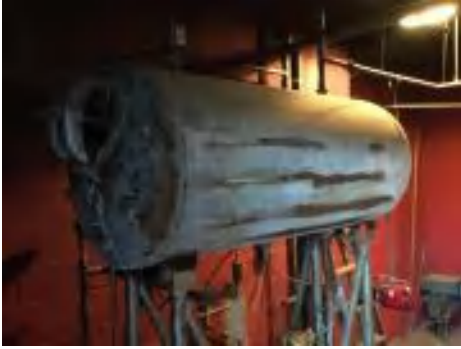
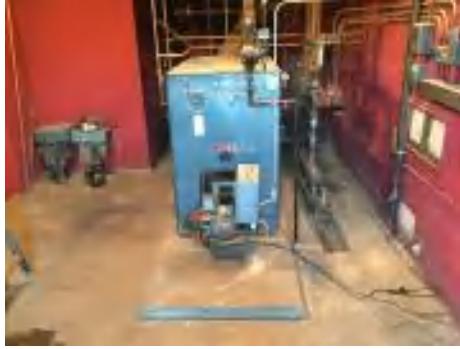
System: D3020 - Heat Generating Systems

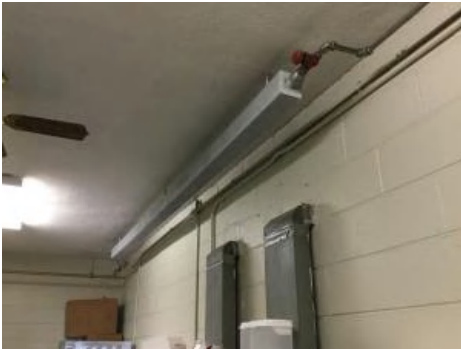
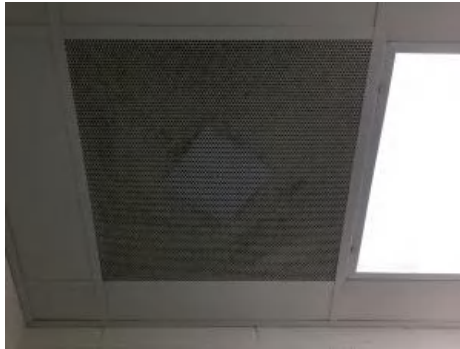
System: D3040 - Distribution Systems

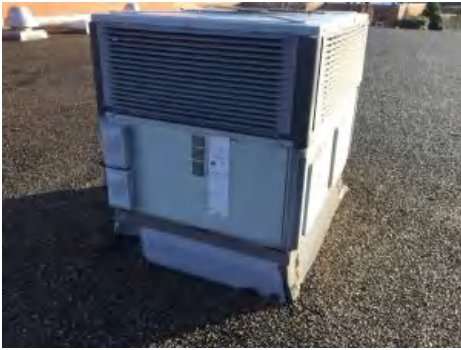
System: D3050 - Terminal & Package Units

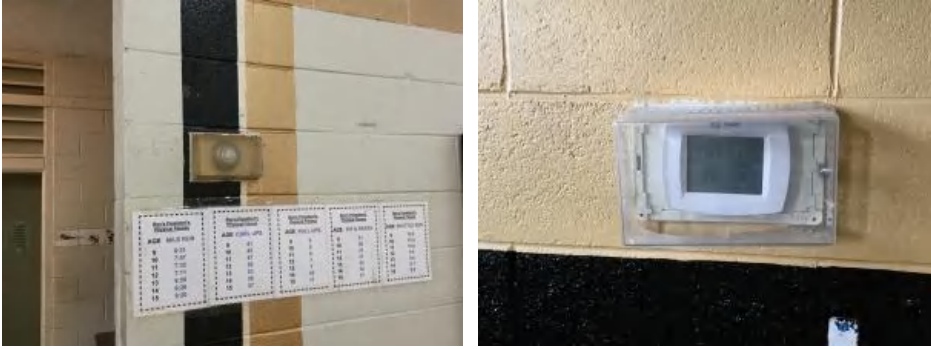
System: D3060 - Controls & Instrumentation

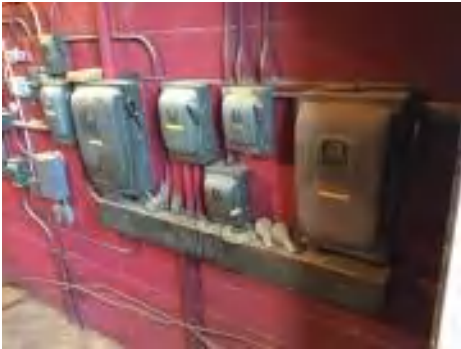
System: D5010 - Electrical Service/Distribution

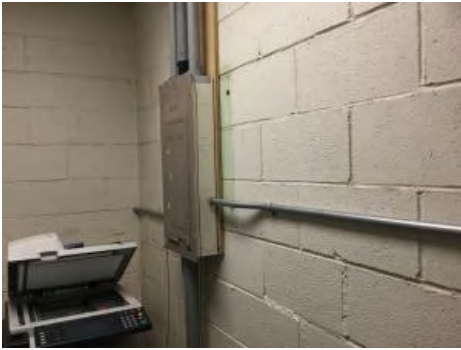
System: D5020 - Branch Wiring

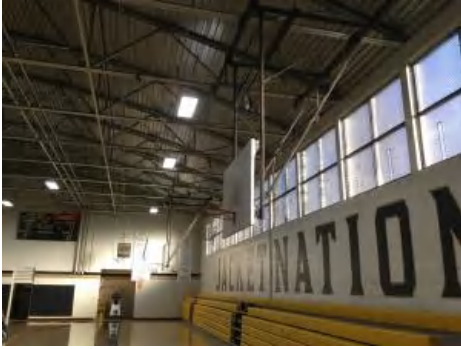
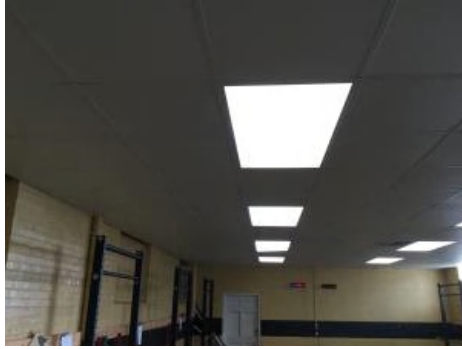
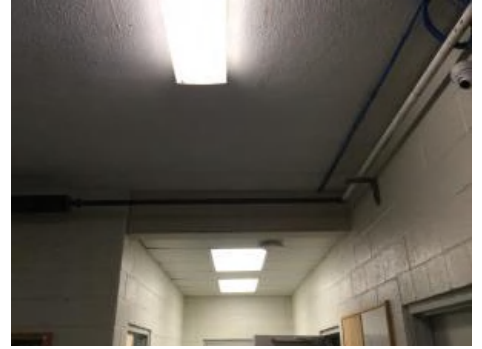
System: D5020 - Lighting

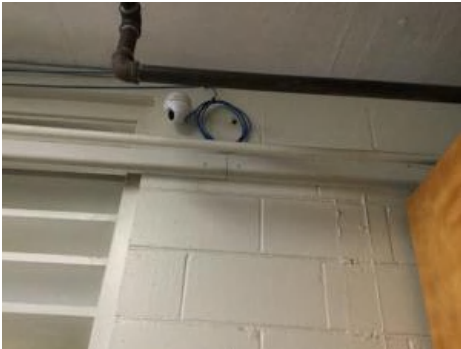
System: D5030810 - Security & Detection Systems

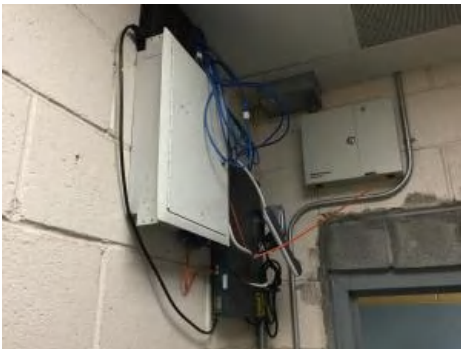
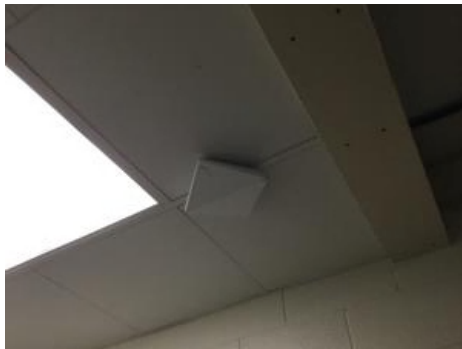
System: D5030920 - Data Communication

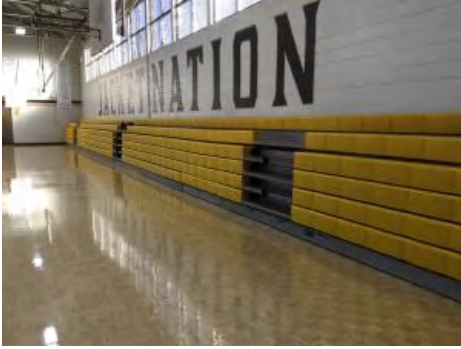
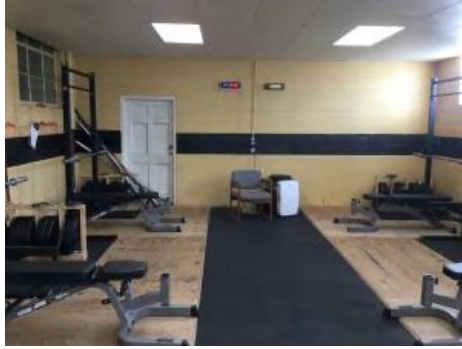
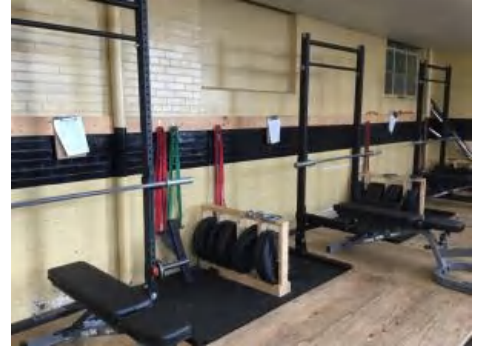
System: E1090 - Other Equipment

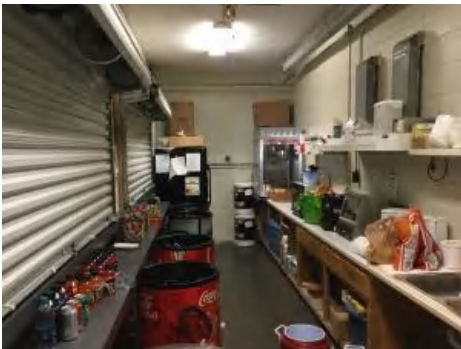
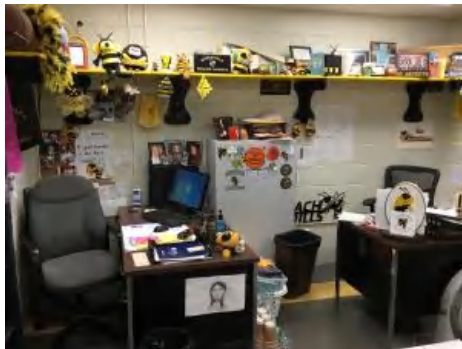
System: E2010 - Fixed Furnishings

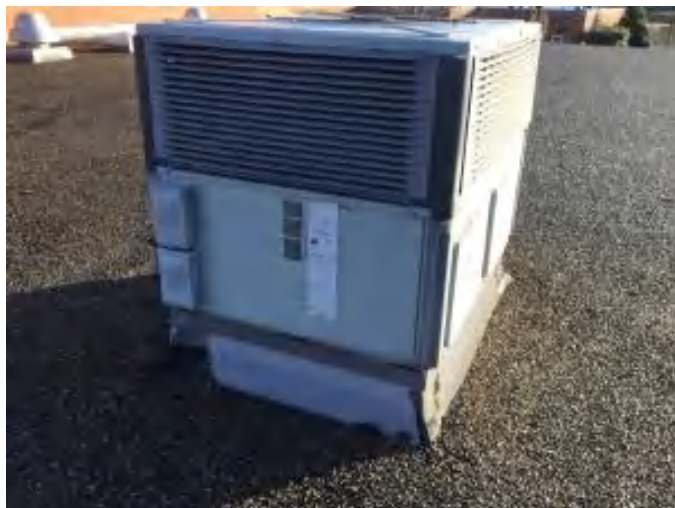
System: D3050 - Terminal & Package Units

Location: Roof
Distress: Beyond Service Life
Category: Deferred Maintenance
Priority: 3 - Necessary/Not Yet Critical (Years 2-5)
Correction: Renew System
Qty: 14,400.00
Unit of Measure: S.F.
Estimate: \$254,074.00
Assessor Name: Eduardo Lopez
Date Created: 02/09/2017

Notes: The roof mounted DX condensing unit is aged and should be scheduled for replacement.

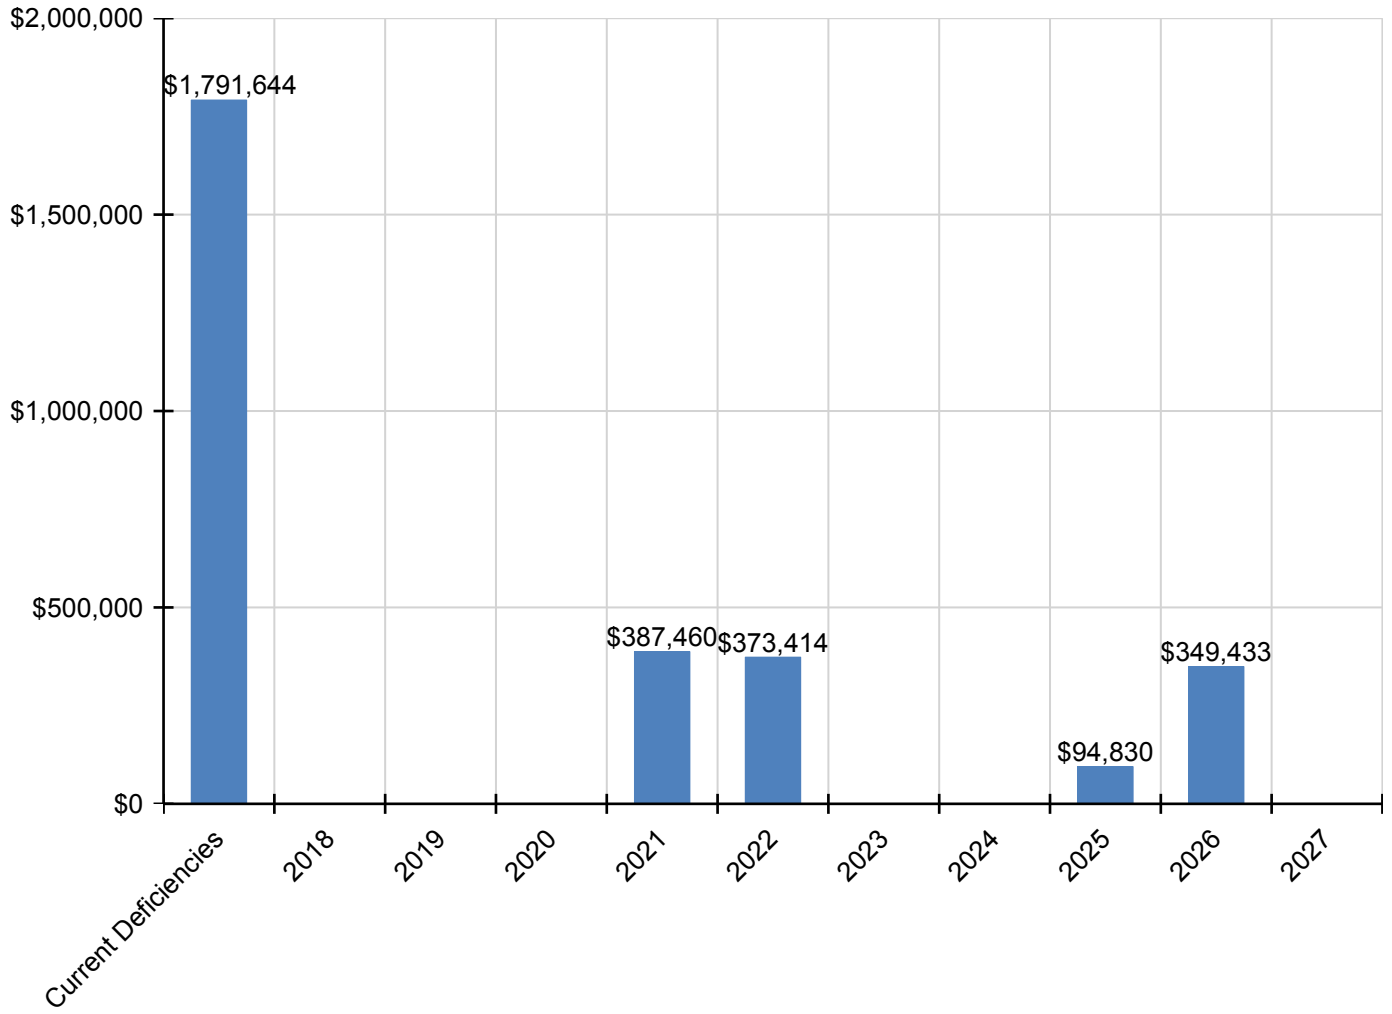
Forecasted Capital Renewal Requirement

The following chart shows the current building deficiencies and forecasting capital renewal or sustainment requirements over the next ten years.

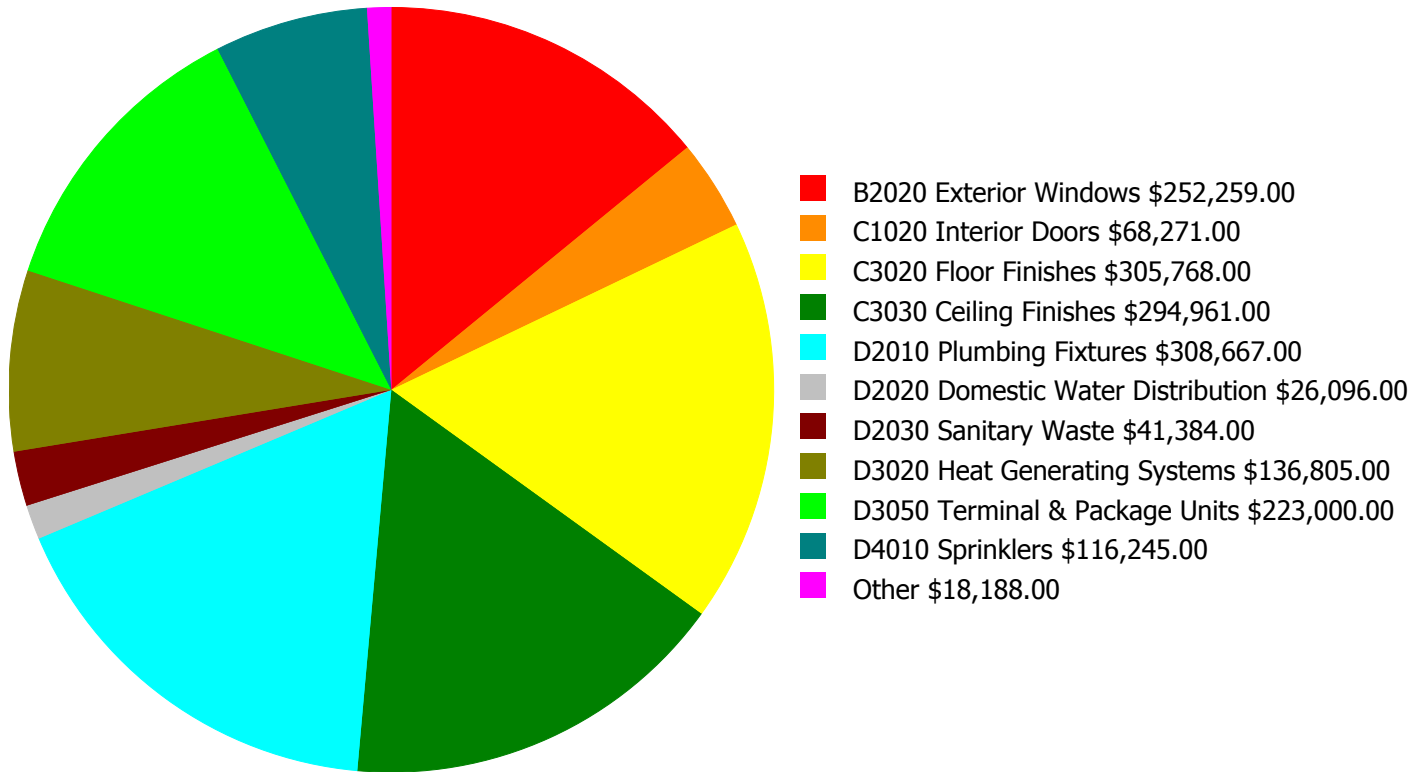
Deficiency Summary by System

Current deficiencies included assemblies that have reached or exceeded their design life or components of the assemblies that are in need of repair. Assemblies that have reached their design life are identified as current deficiencies and assigned the distress 'Beyond Useful Life'. The following chart lists all current deficiencies associated with this facility.

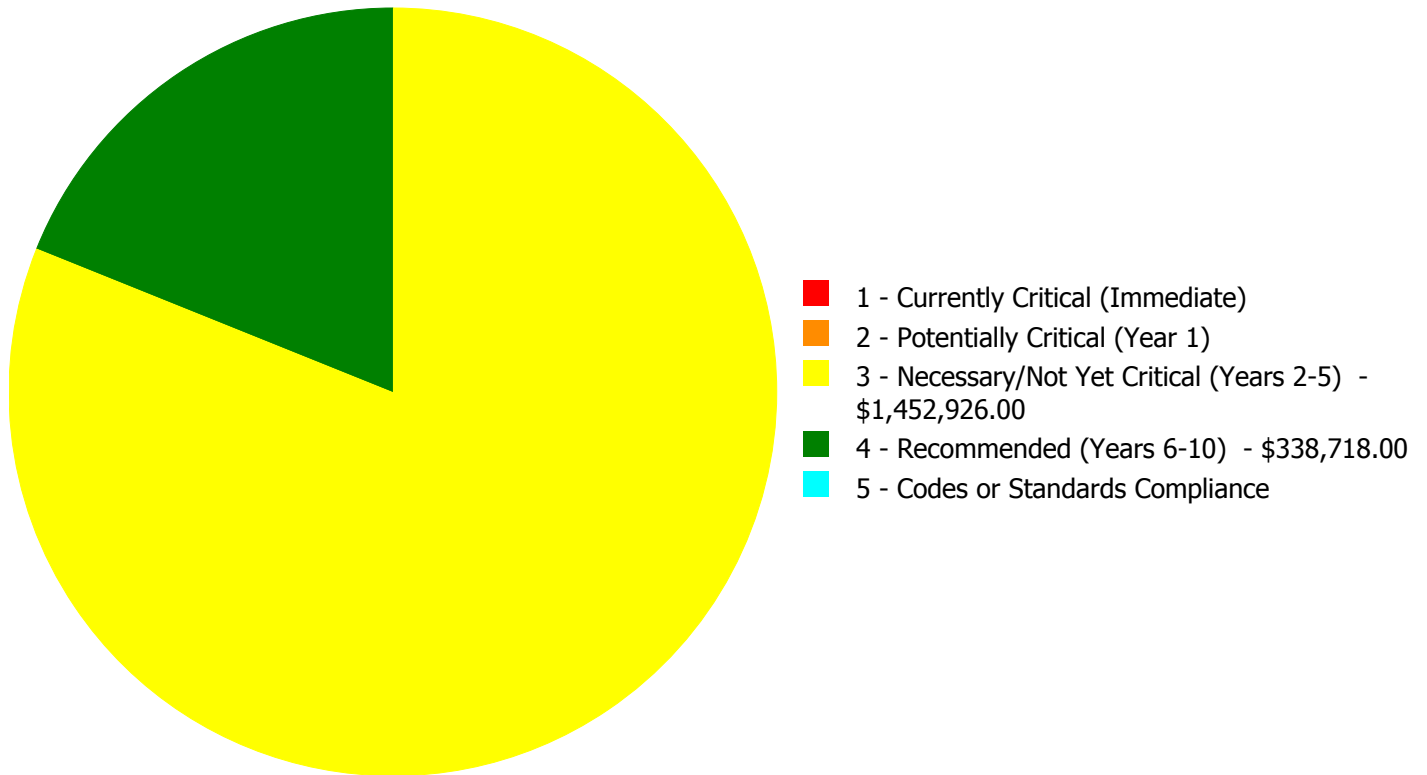
Deficiency Summary by Priority

The following chart shows the total repair costs broken down by priority. Assessors assigned deficiencies within eCOMET to one of the following priority categories:

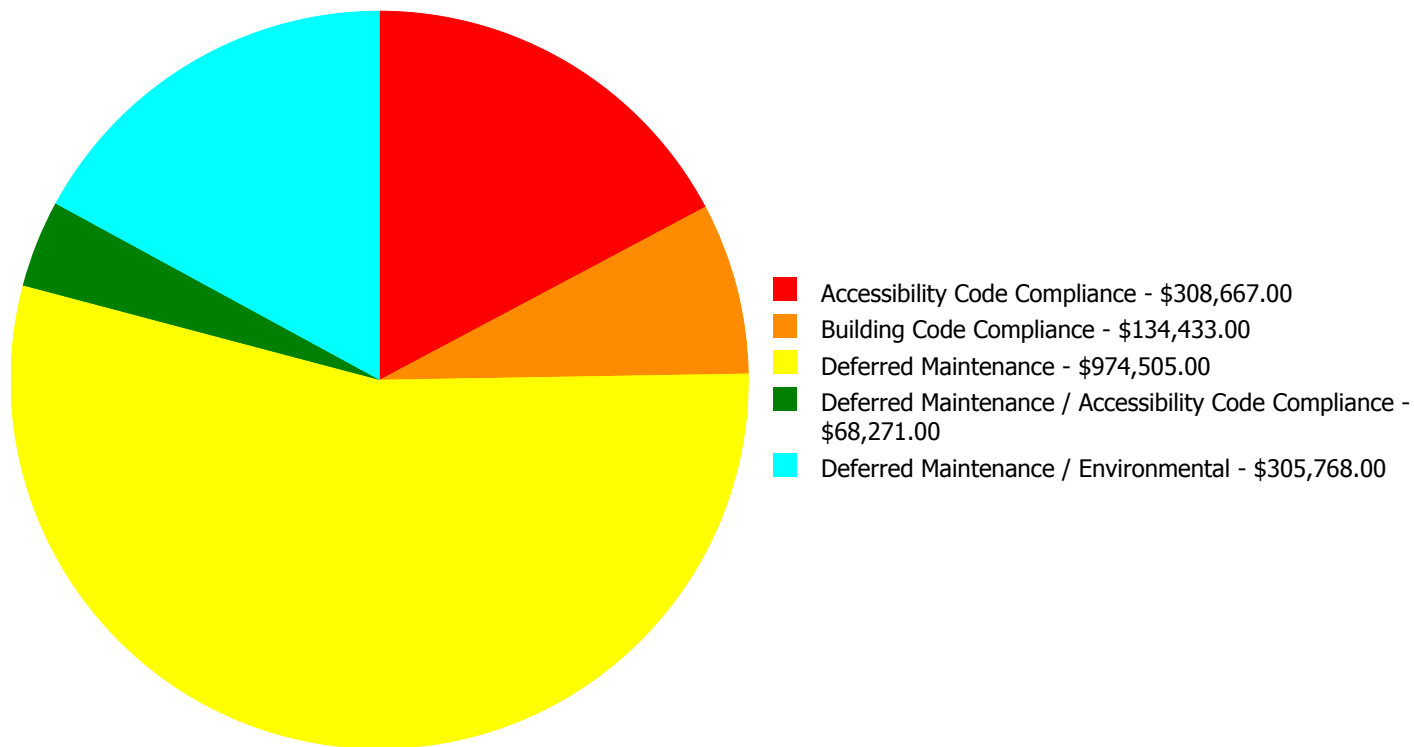
Deficiency Summary by Category

The following chart shows the total repair costs broken down by deficiency categories. Assessors assigned deficiencies to one of the following categories:

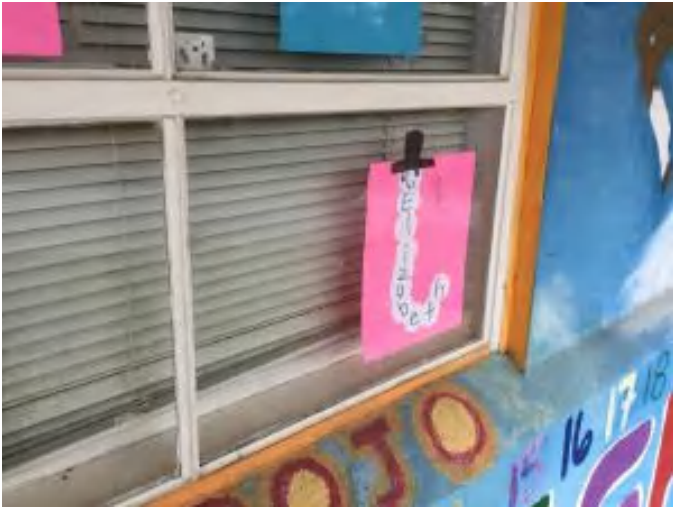
System: B2020 - Exterior Windows

Location: Exterior
Distress: Failing
Category: Deferred Maintenance
Priority: 3 - Necessary/Not Yet Critical (Years 2-5)
Correction: Renew System
Qty: 23,963.00
Unit of Measure: S.F.
Estimate: \$252,259.00
Assessor Name: Eduardo Lopez
Date Created: 02/09/2017

Notes: The original metal frame, single pane, operable windows are aged, worn, inefficient and should be replaced.

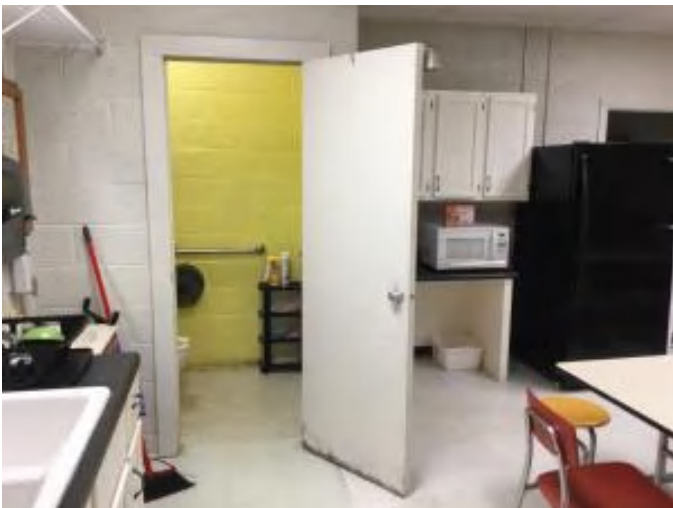
System: C1020 - Interior Doors

Location: Classroom Restrooms
Distress: Damaged
Category: Deferred Maintenance / Accessibility Code Compliance
Priority: 3 - Necessary/Not Yet Critical (Years 2-5)
Correction: Renew System
Qty: 23,963.00
Unit of Measure: S.F.
Estimate: \$68,271.00
Assessor Name: Eduardo Lopez
Date Created: 02/09/2017

Notes: The interior doors are aged, frames are rusting and damaged, and the hardware is not ADA compliant and should be replaced.

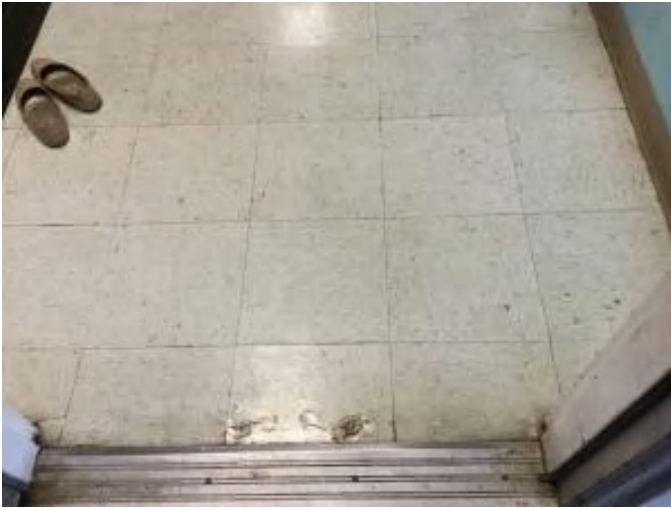
System: C3020 - Floor Finishes

Location: Throughout the building
Distress: Damaged
Category: Deferred Maintenance / Environmental
Priority: 3 - Necessary/Not Yet Critical (Years 2-5)
Correction: Renew System
Qty: 23,963.00
Unit of Measure: S.F.
Estimate: \$305,768.00
Assessor Name: Eduardo Lopez
Date Created: 02/09/2017

Notes: The floor covering is aged, damaged in some areas and beyond its service life.
