NC School District/220 Clay County/High School

Hayesville High

Campus Assessment Report

March 7, 2017

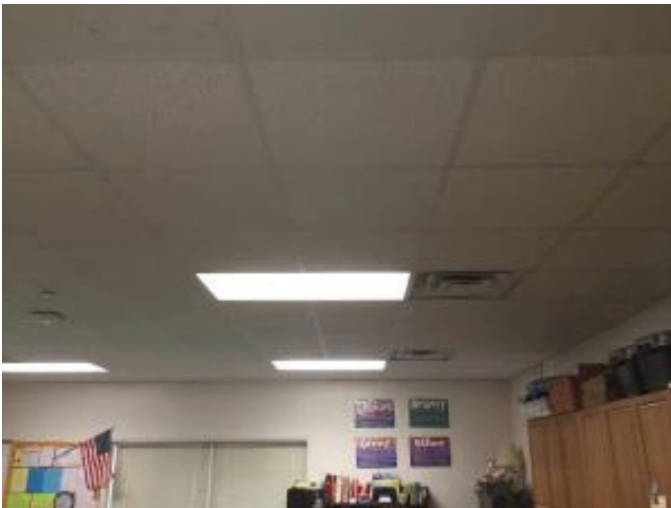
System: C3030 - Ceiling Finishes

Location: Throughout the building
Distress: Damaged
Category: Deferred Maintenance
Priority: 3 - Necessary/Not Yet Critical (Years 2-5)
Correction: Renew System
Qty: 23,963.00
Unit of Measure: S.F.
Estimate: \$294,961.00
Assessor Name: Eduardo Lopez
Date Created: 02/09/2017

Notes: The original ceiling finishes are aged, tiles are sagging or damaged and should be replaced.

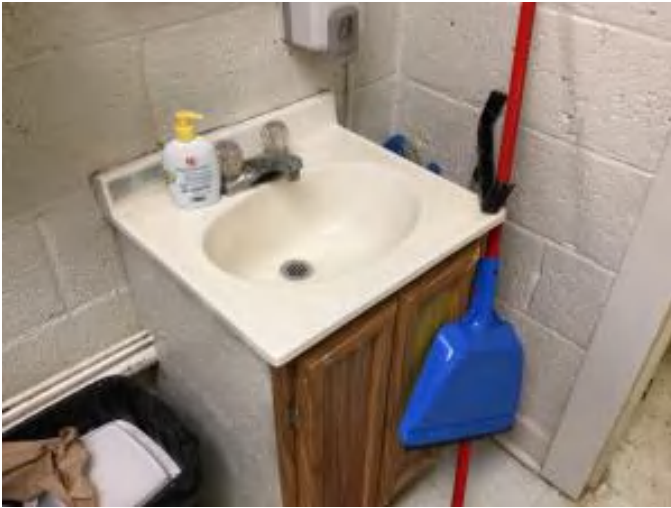
System: D2010 - Plumbing Fixtures

Location: Classrooms
Distress: Inadequate
Category: Accessibility Code Compliance
Priority: 3 - Necessary/Not Yet Critical (Years 2-5)
Correction: Renew System
Qty: 23,963.00
Unit of Measure: S.F.
Estimate: \$308,667.00
Assessor Name: Eduardo Lopez
Date Created: 02/09/2017

Notes: Plumbing fixtures are in operational conditions. However, they are aged, not ADA compliant and should be replaced with a low-flow water fixtures.

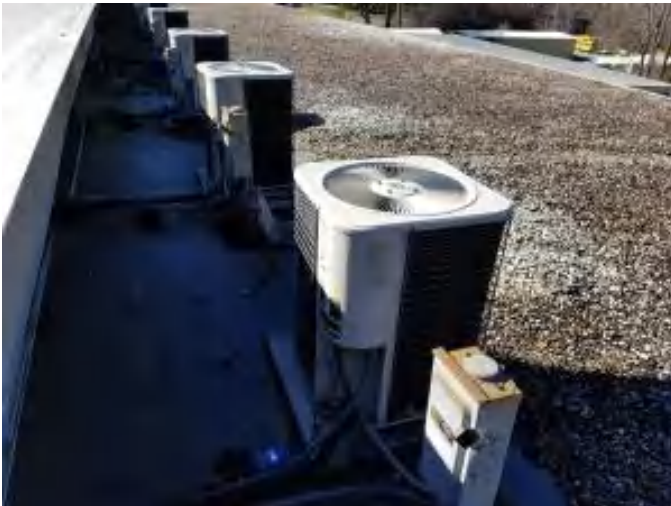
System: D3050 - Terminal & Package Units

Location: Roof
Distress: Beyond Service Life
Category: Deferred Maintenance
Priority: 3 - Necessary/Not Yet Critical (Years 2-5)
Correction: Renew System
Qty: 23,963.00
Unit of Measure: S.F.
Estimate: \$223,000.00
Assessor Name: Eduardo Lopez
Date Created: 02/09/2017

Notes: The AC units are beyond their expected service life, requires extensive maintenance and should be scheduled for replacement.

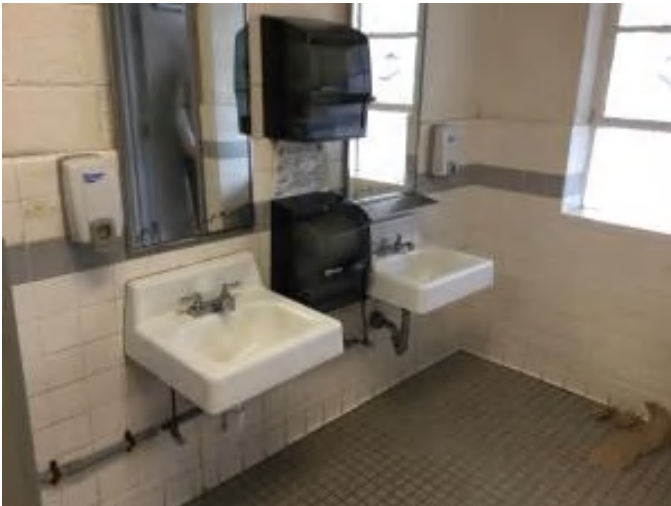
System: D2020 - Domestic Water Distribution

Location: Throughout the building
Distress: Beyond Service Life
Category: Deferred Maintenance
Priority: 4 - Recommended (Years 6-10)
Correction: Renew System
Qty: 23,963.00
Unit of Measure: S.F.
Estimate: \$26,096.00
Assessor Name: Eduardo Lopez
Date Created: 02/09/2017

Notes: There are no reported issues or observed deficiencies with the domestic water piping. Due to the age of the copper pipe there can be internal pitting corrosion that may be a costly problem that leads to the formation of pinhole leaks and possible water contamination. Corrosion can build-up on the inside walls of the pipes and create the potential for lead to accumulate over time.

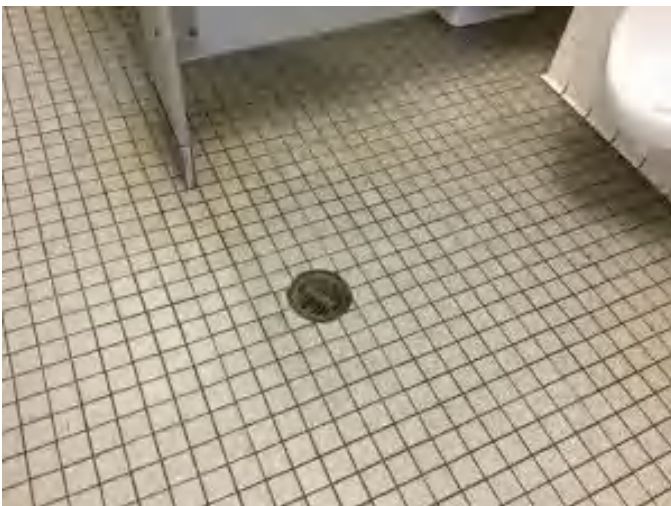
System: D2030 - Sanitary Waste

Location: Throughout the building
Distress: Beyond Service Life
Category: Deferred Maintenance
Priority: 4 - Recommended (Years 6-10)
Correction: Renew System
Qty: 23,963.00
Unit of Measure: S.F.
Estimate: \$41,384.00
Assessor Name: Eduardo Lopez
Date Created: 02/09/2017

Notes: There are no reported issues or observed deficiencies with the sanitary waste piping. The aging sanitary sewer piping is subject to leaks, infiltration, and it can even collapse in the interior walls. The system should be inspected with cameras to ensure that none of these deficiencies exist.

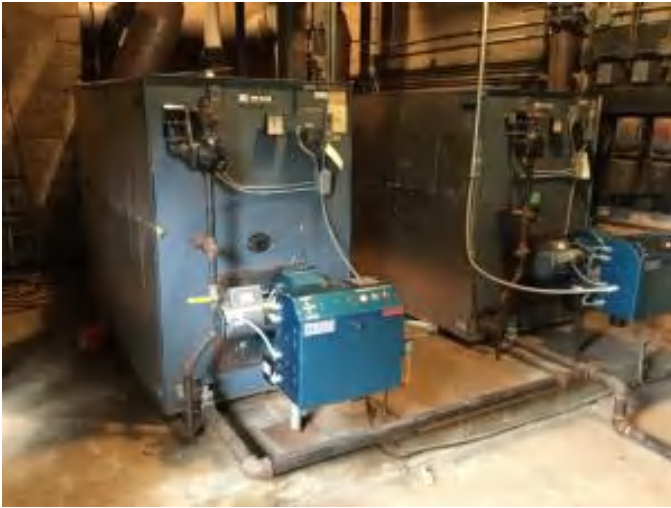
System: D3020 - Heat Generating Systems

Location: Boiler Room
Distress: Beyond Service Life
Category: Deferred Maintenance
Priority: 4 - Recommended (Years 6-10)
Correction: Renew System
Qty: 23,963.00
Unit of Measure: S.F.
Estimate: \$136,805.00
Assessor Name: Eduardo Lopez
Date Created: 02/09/2017

Notes: The boilers are well maintained and functions as designed, but are beyond their service life and should be considered for replacement.

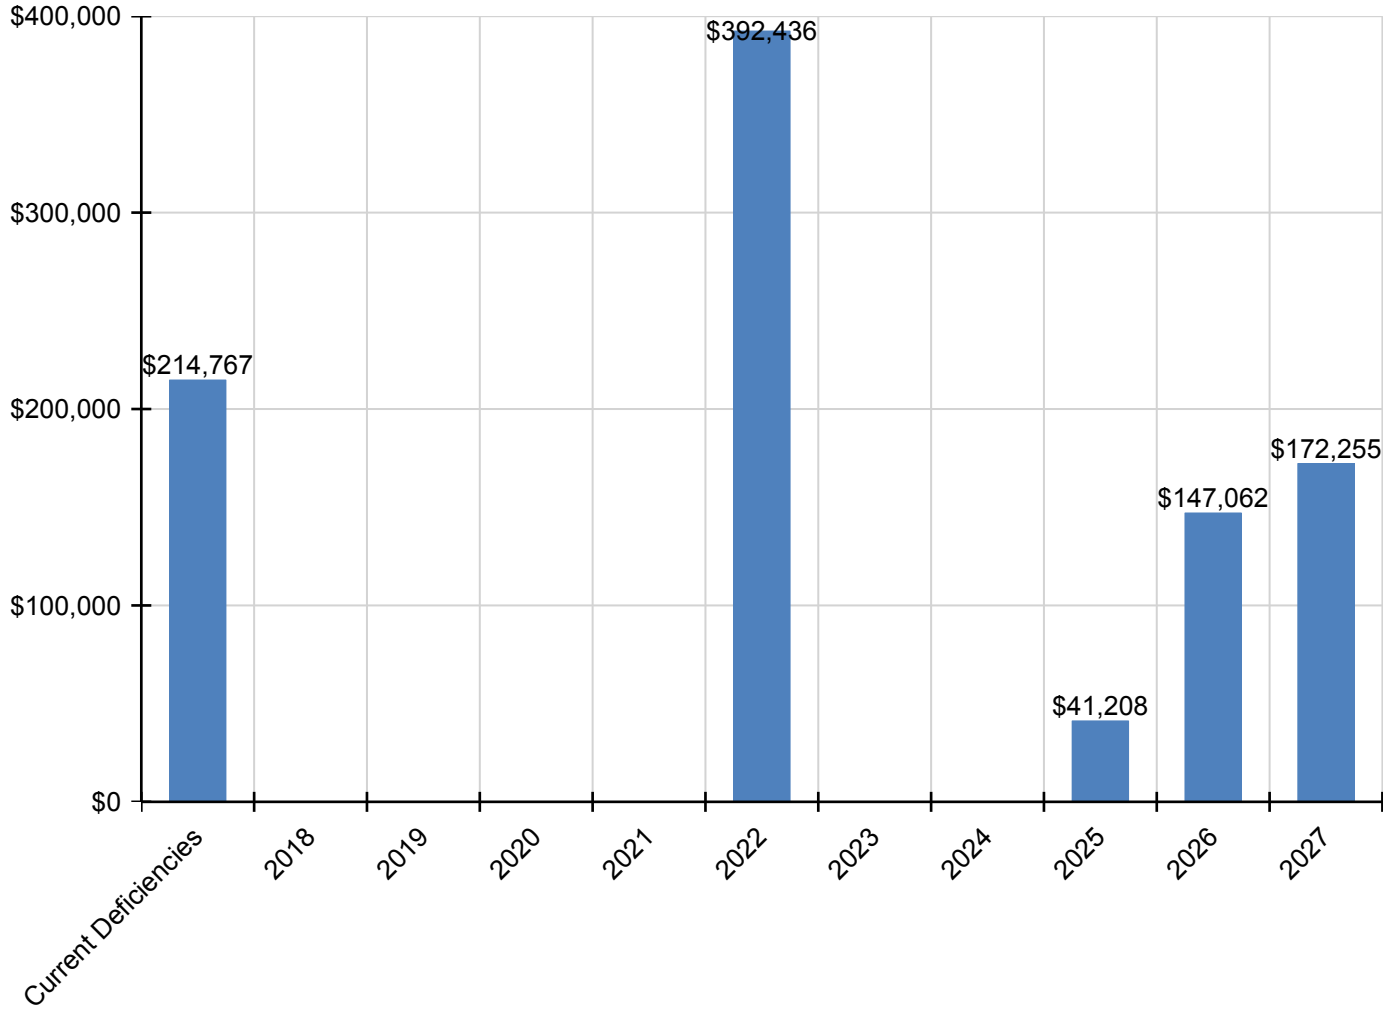
Forecasted Capital Renewal Requirement

The following chart shows the current building deficiencies and forecasting capital renewal or sustainment requirements over the next ten years.

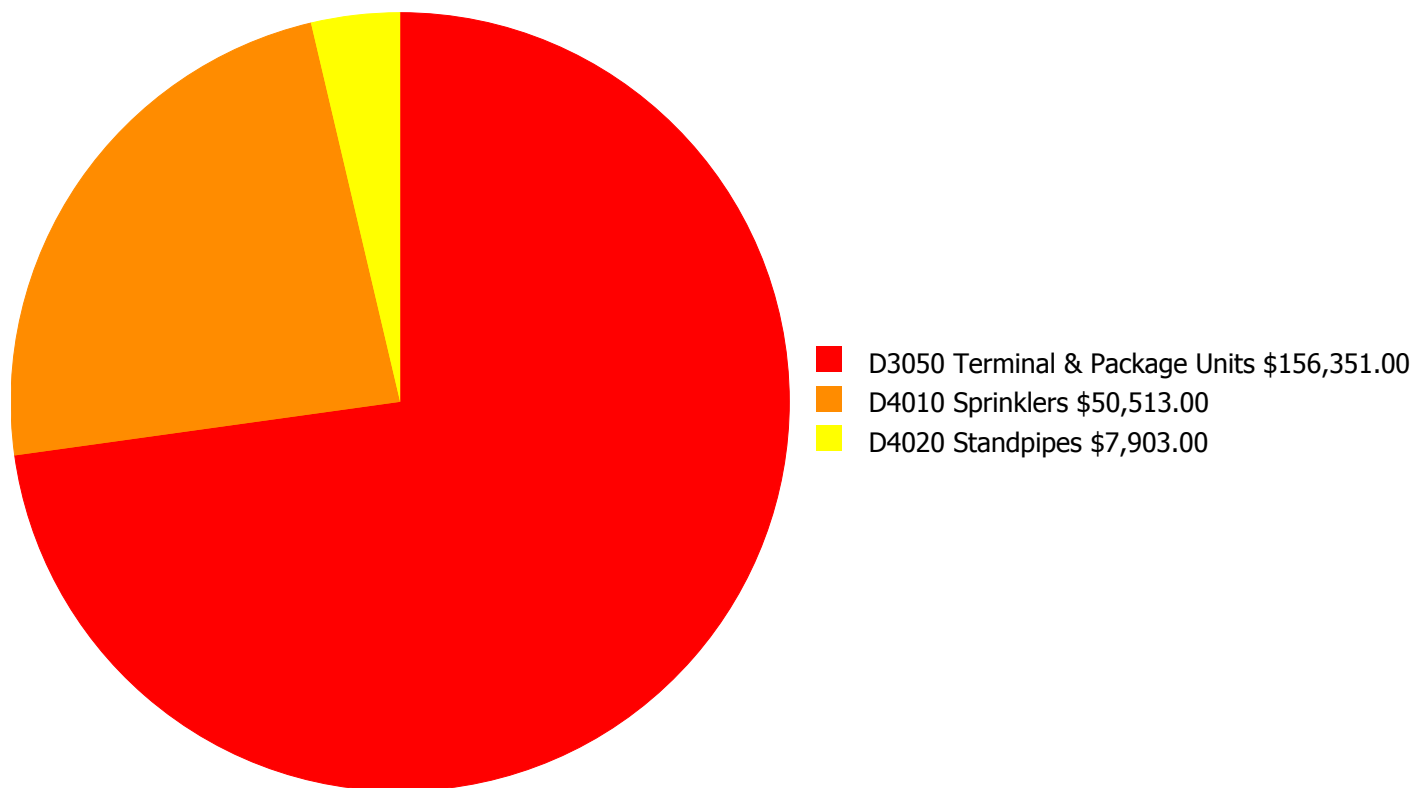
Deficiency Summary by System

Current deficiencies included assemblies that have reached or exceeded their design life or components of the assemblies that are in need of repair. Assemblies that have reached their design life are identified as current deficiencies and assigned the distress 'Beyond Useful Life'. The following chart lists all current deficiencies associated with this facility.

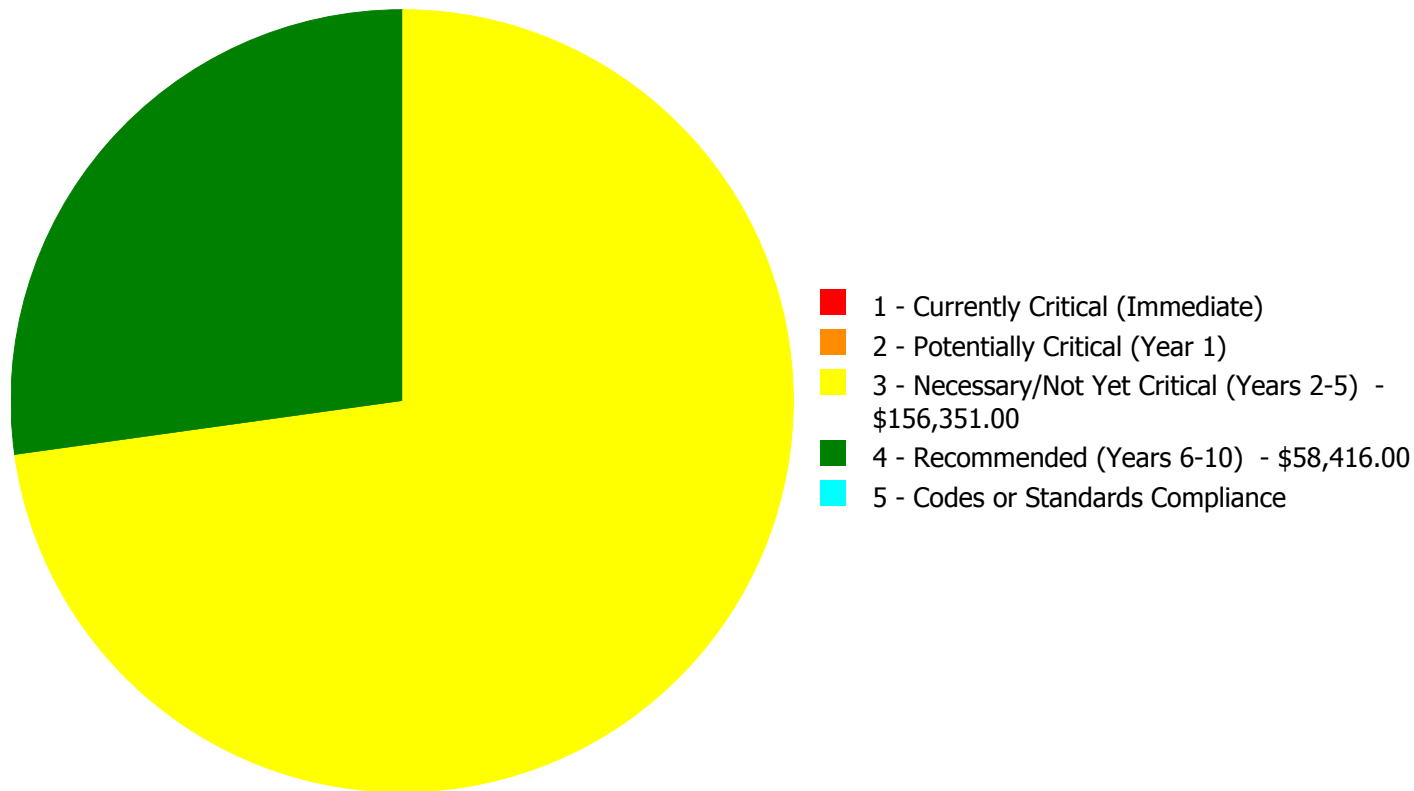
Deficiency Summary by Priority

The following chart shows the total repair costs broken down by priority. Assessors assigned deficiencies within eCOMET to one of the following priority categories:

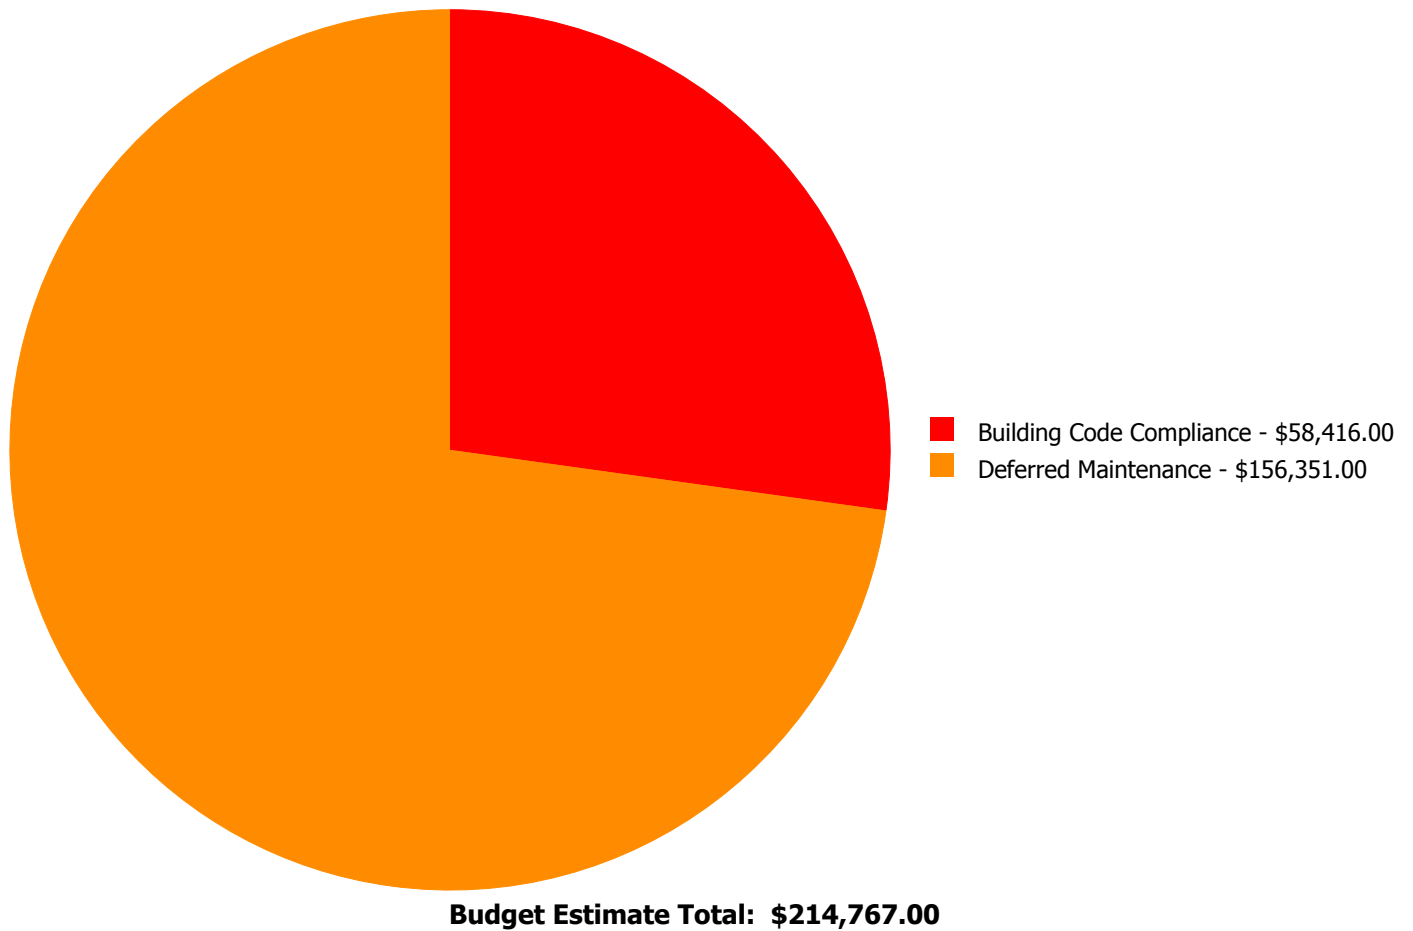
Deficiency Summary by Category

The following chart shows the total repair costs broken down by deficiency categories. Assessors assigned deficiencies to one of the following categories:

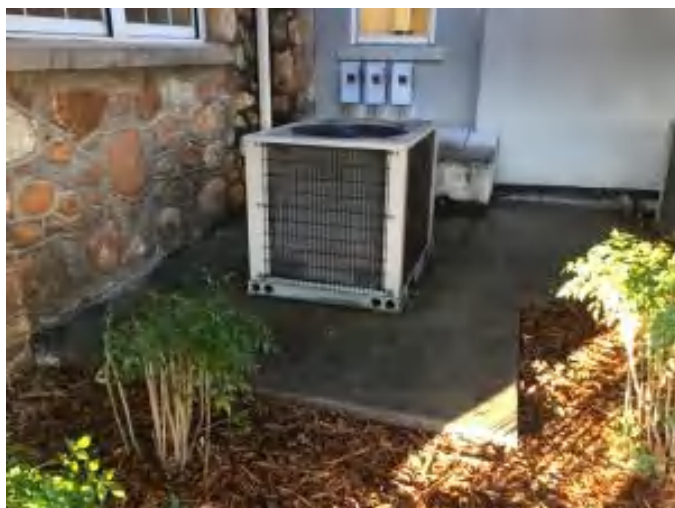
System: D3050 - Terminal & Package Units

Location: Exterior
Distress: Beyond Service Life
Category: Deferred Maintenance
Priority: 3 - Necessary/Not Yet Critical (Years 2-5)
Correction: Renew System
Qty: 10,413.00
Unit of Measure: S.F.
Estimate: \$156,351.00
Assessor Name: Eduardo Lopez
Date Created: 02/09/2017

Notes: The pad mounted units are aged and should be scheduled for replacement.

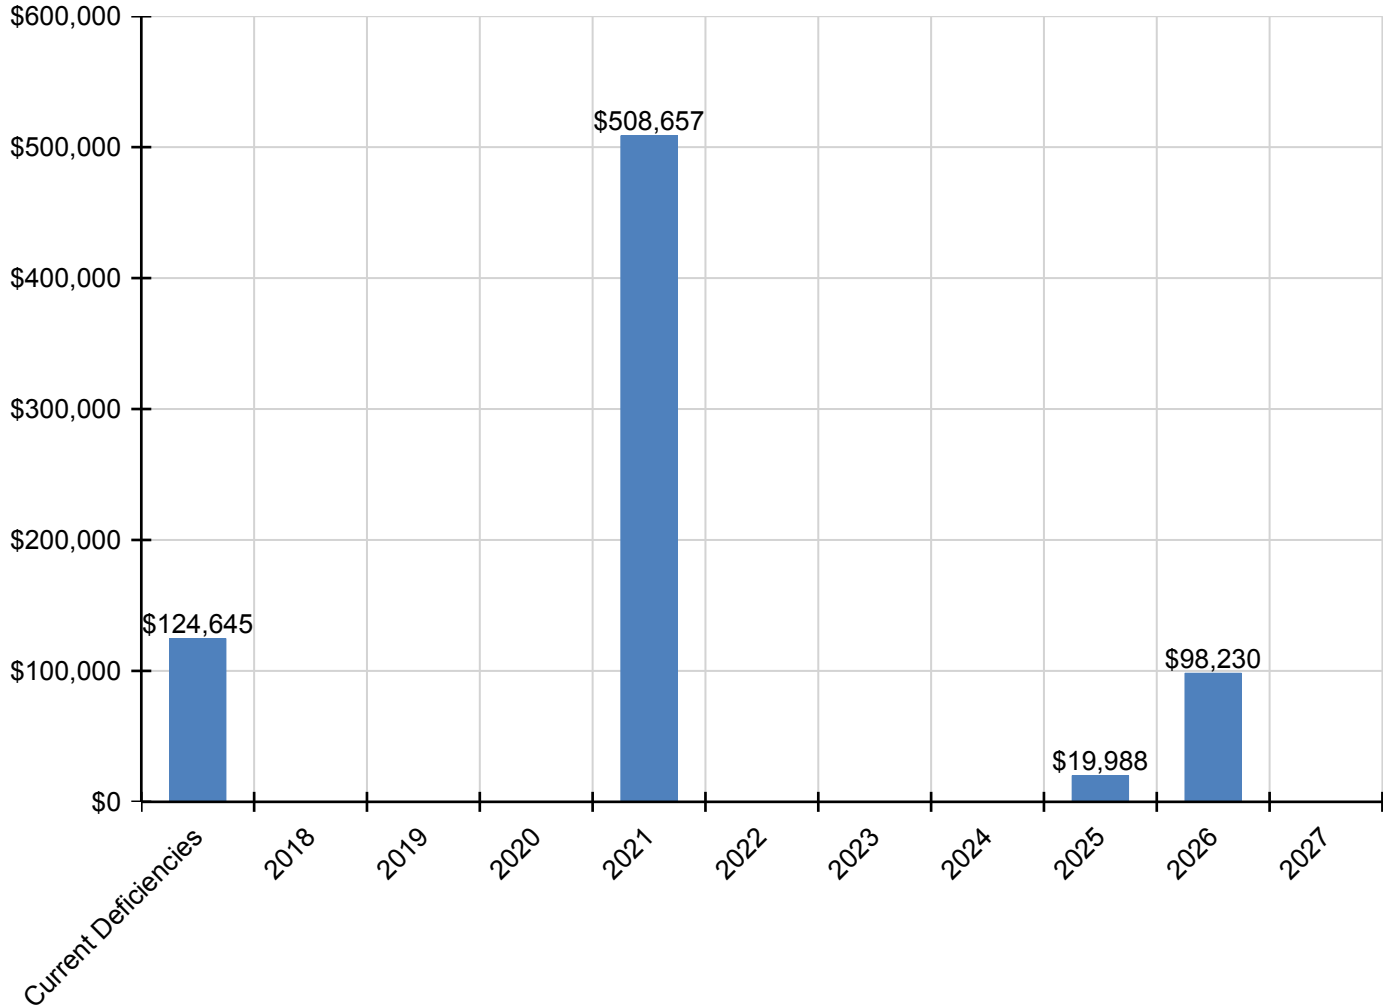
Forecasted Capital Renewal Requirement

The following chart shows the current building deficiencies and forecasting capital renewal or sustainment requirements over the next ten years.

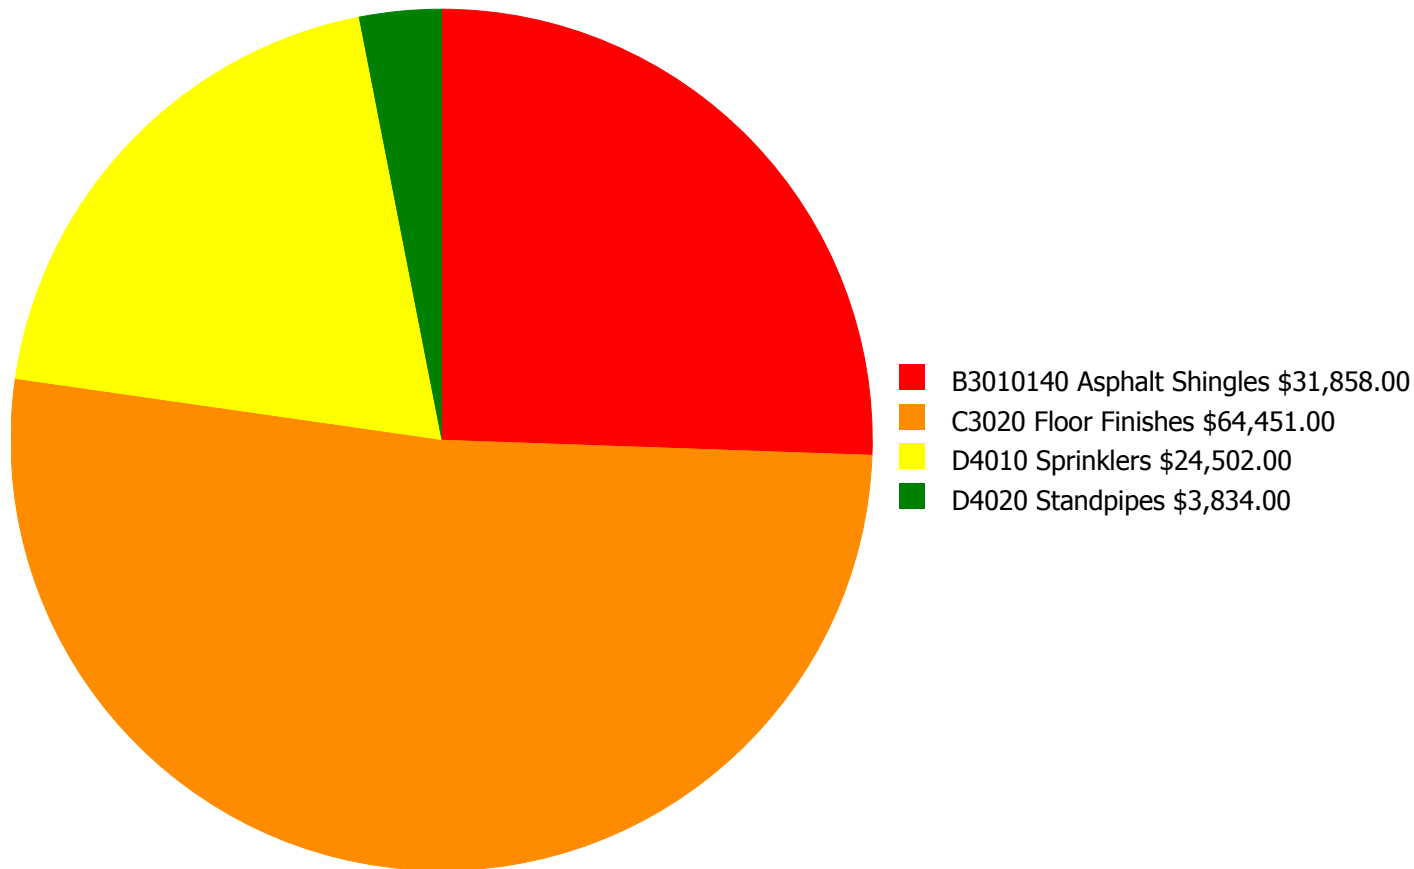
Deficiency Summary by System

Current deficiencies included assemblies that have reached or exceeded their design life or components of the assemblies that are in need of repair. Assemblies that have reached their design life are identified as current deficiencies and assigned the distress 'Beyond Useful Life'. The following chart lists all current deficiencies associated with this facility.

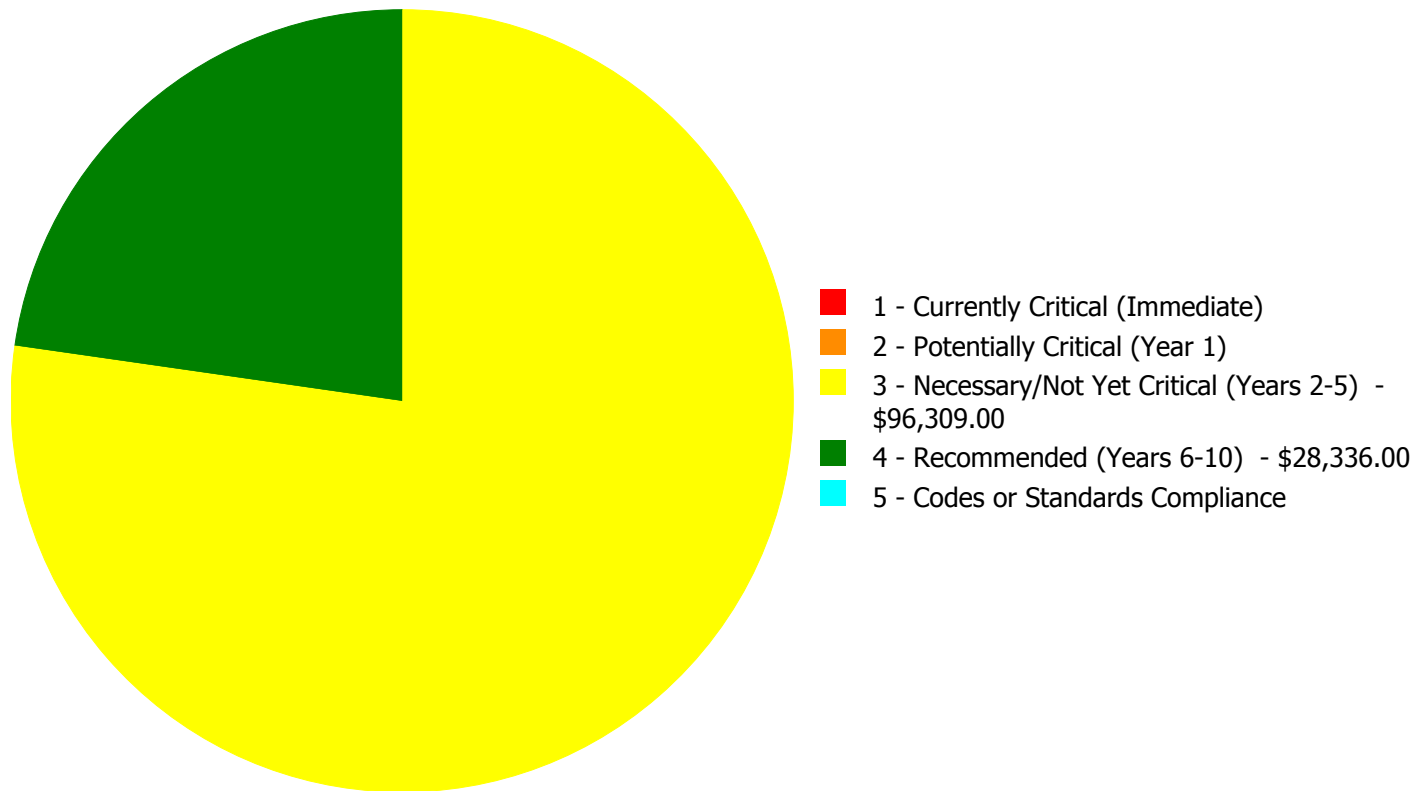
Deficiency Summary by Priority

The following chart shows the total repair costs broken down by priority. Assessors assigned deficiencies within eCOMET to one of the following priority categories:

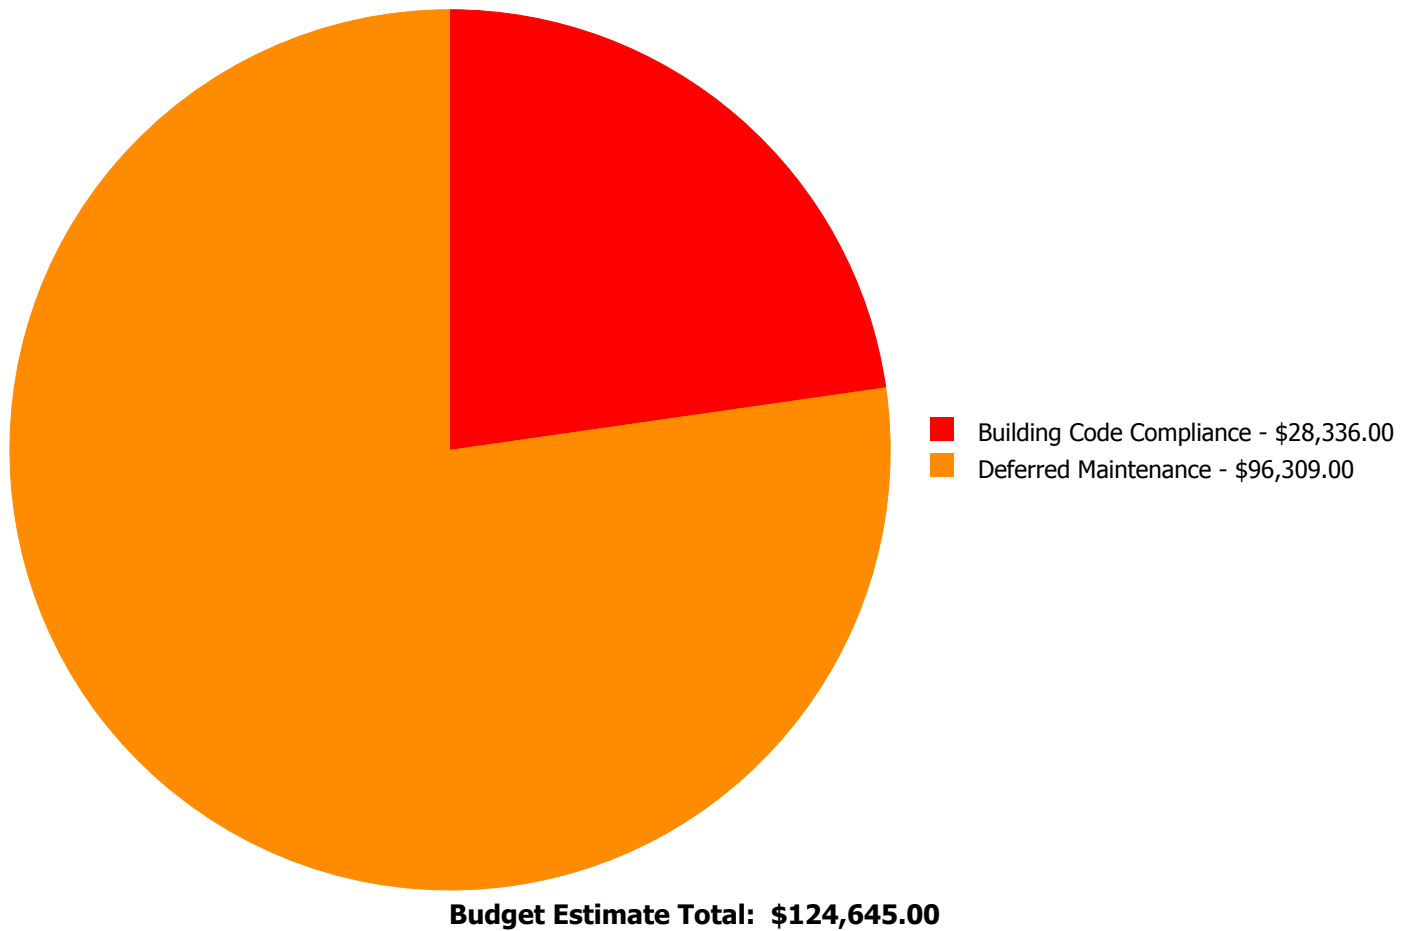
Deficiency Summary by Category

The following chart shows the total repair costs broken down by deficiency categories. Assessors assigned deficiencies to one of the following categories:

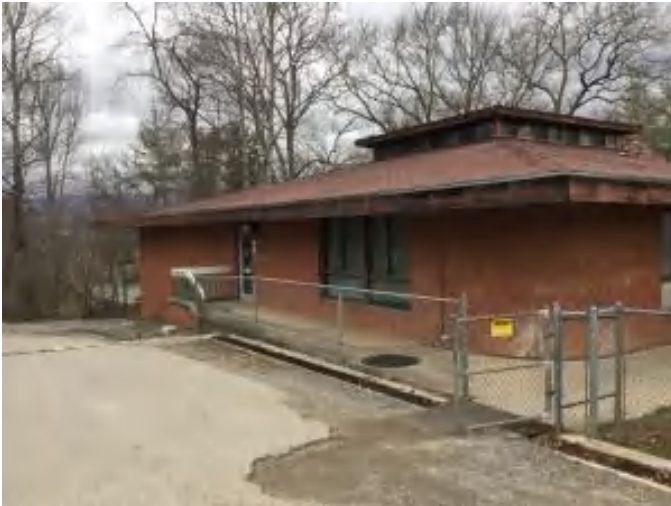
System: B3010140 - Asphalt Shingles

Location: Roof
Distress: Beyond Service Life
Category: Deferred Maintenance
Priority: 3 - Necessary/Not Yet Critical (Years 2-5)
Correction: Renew System
Qty: 5,051.00
Unit of Measure: S.F.
Estimate: \$31,858.00
Assessor Name: Eduardo Lopez
Date Created: 01/18/2017

Notes: The asphalt shingle roofing is aged, damaged and should be replaced.

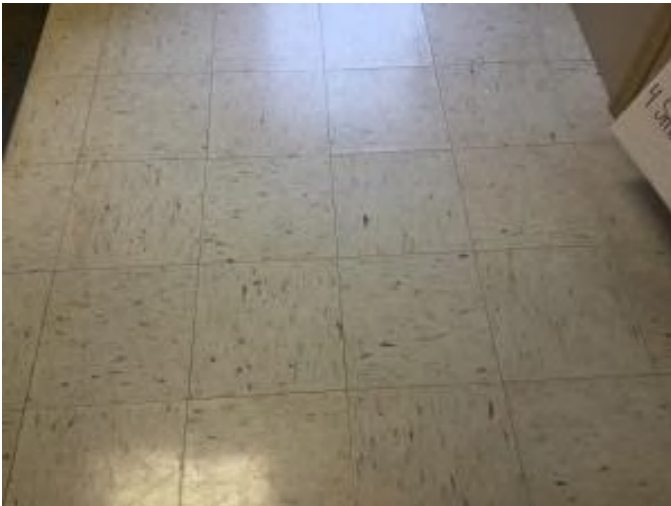
System: C3020 - Floor Finishes

Location: Throughout the building
Distress: Beyond Service Life
Category: Deferred Maintenance
Priority: 3 - Necessary/Not Yet Critical (Years 2-5)
Correction: Renew System
Qty: 5,051.00
Unit of Measure: S.F.
Estimate: \$64,451.00
Assessor Name: Eduardo Lopez
Date Created: 01/18/2017

Notes: The floor covering is aged, damaged in some areas and beyond its service life.

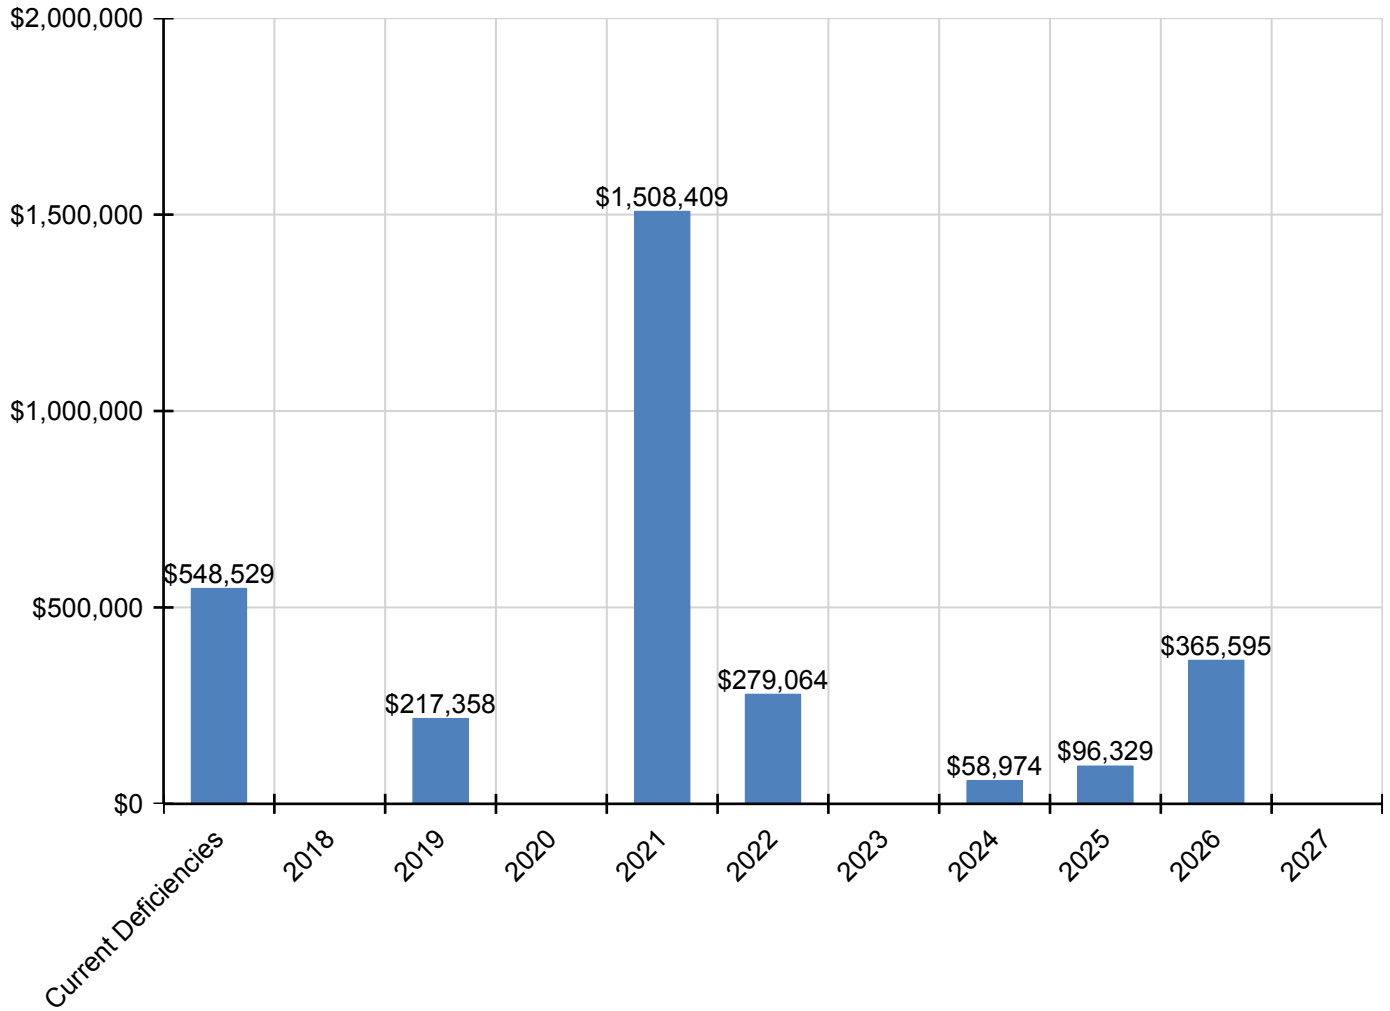
Forecasted Capital Renewal Requirement

The following chart shows the current building deficiencies and forecasting capital renewal or sustainment requirements over the next ten years.

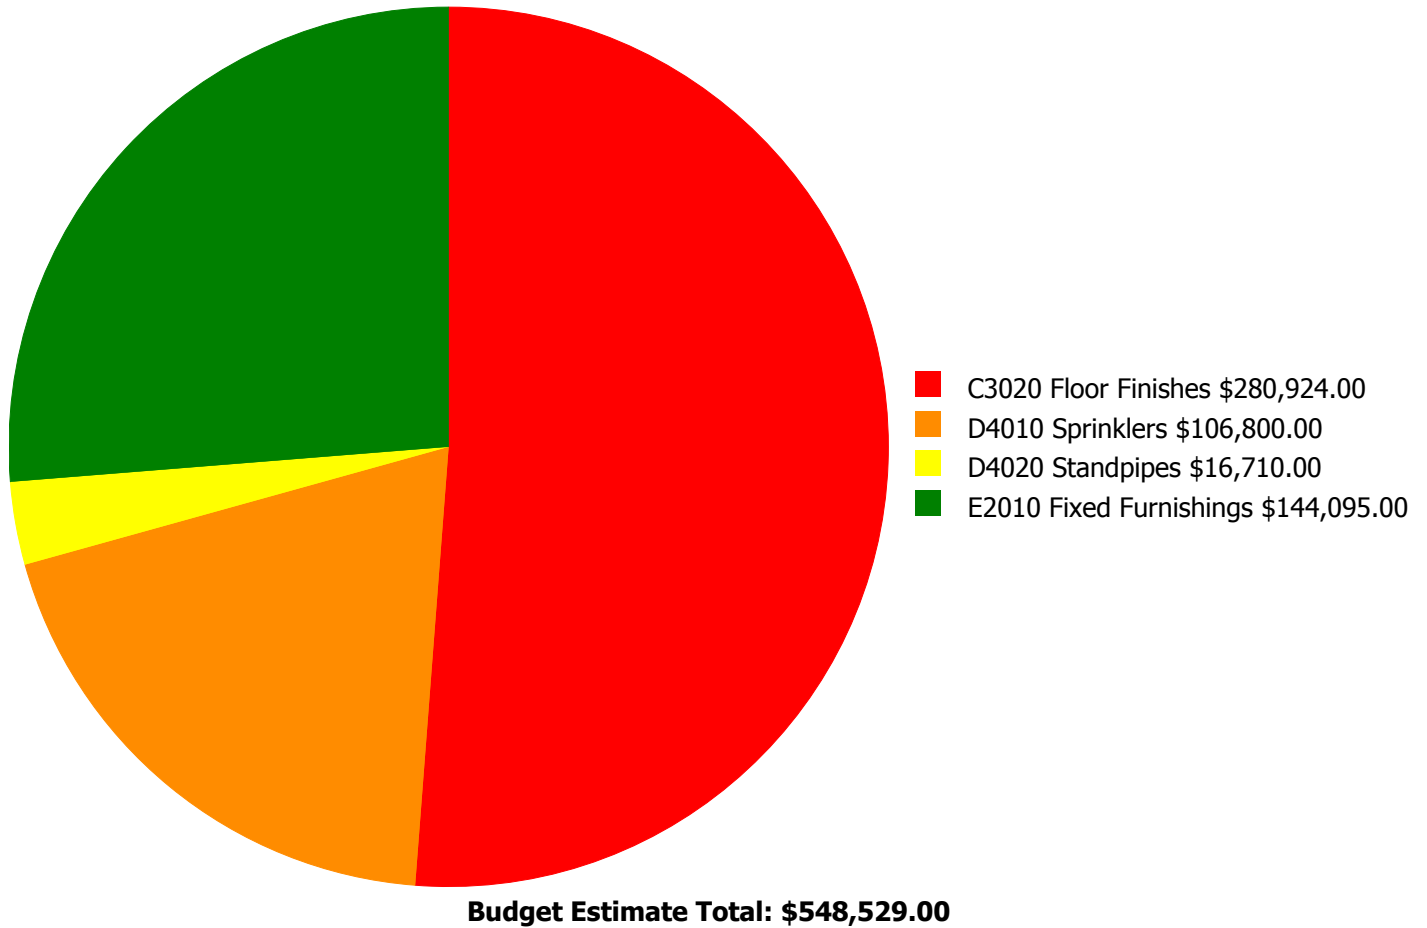
Deficiency Summary by System

Current deficiencies included assemblies that have reached or exceeded their design life or components of the assemblies that are in need of repair. Assemblies that have reached their design life are identified as current deficiencies and assigned the distress 'Beyond Useful Life'. The following chart lists all current deficiencies associated with this facility.

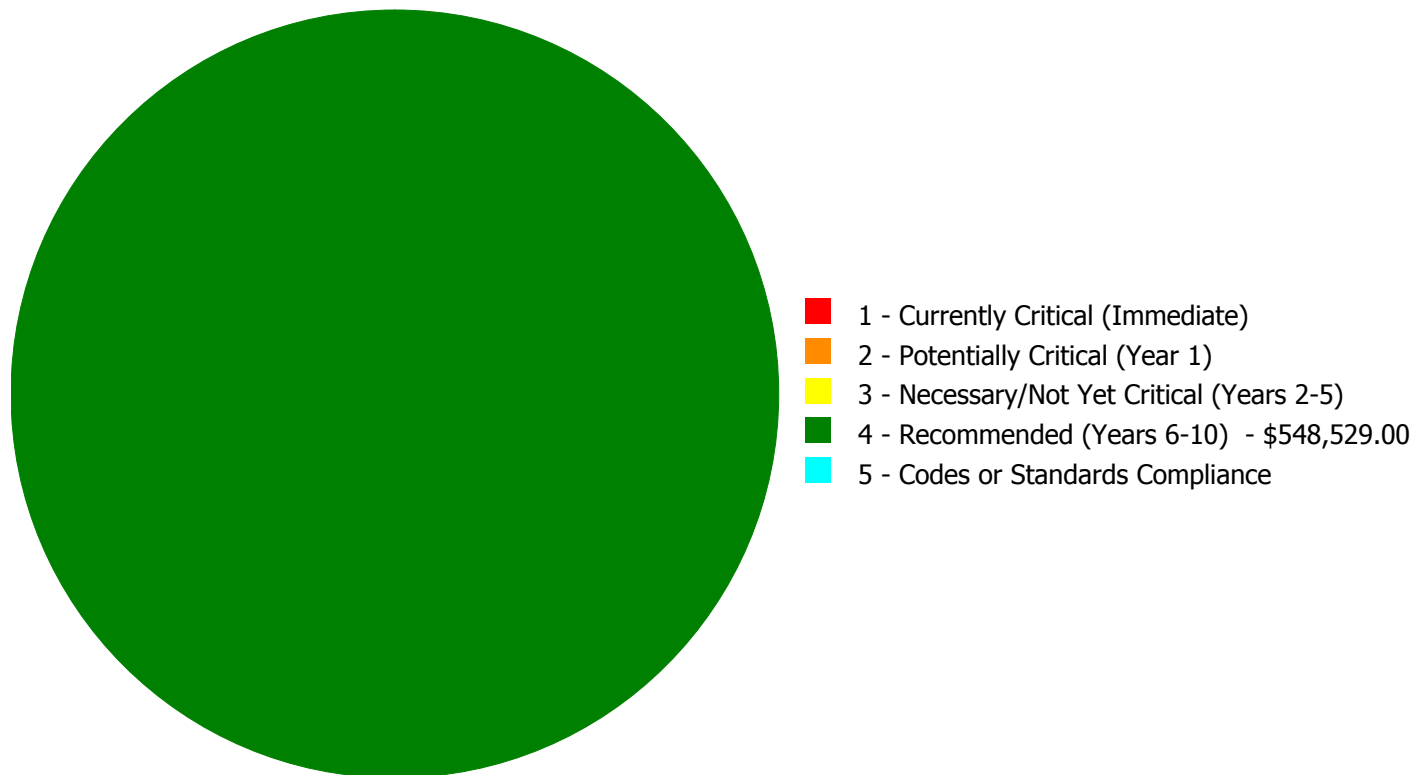
Deficiency Summary by Priority

The following chart shows the total repair costs broken down by priority. Assessors assigned deficiencies within eCOMET to one of the following priority categories:

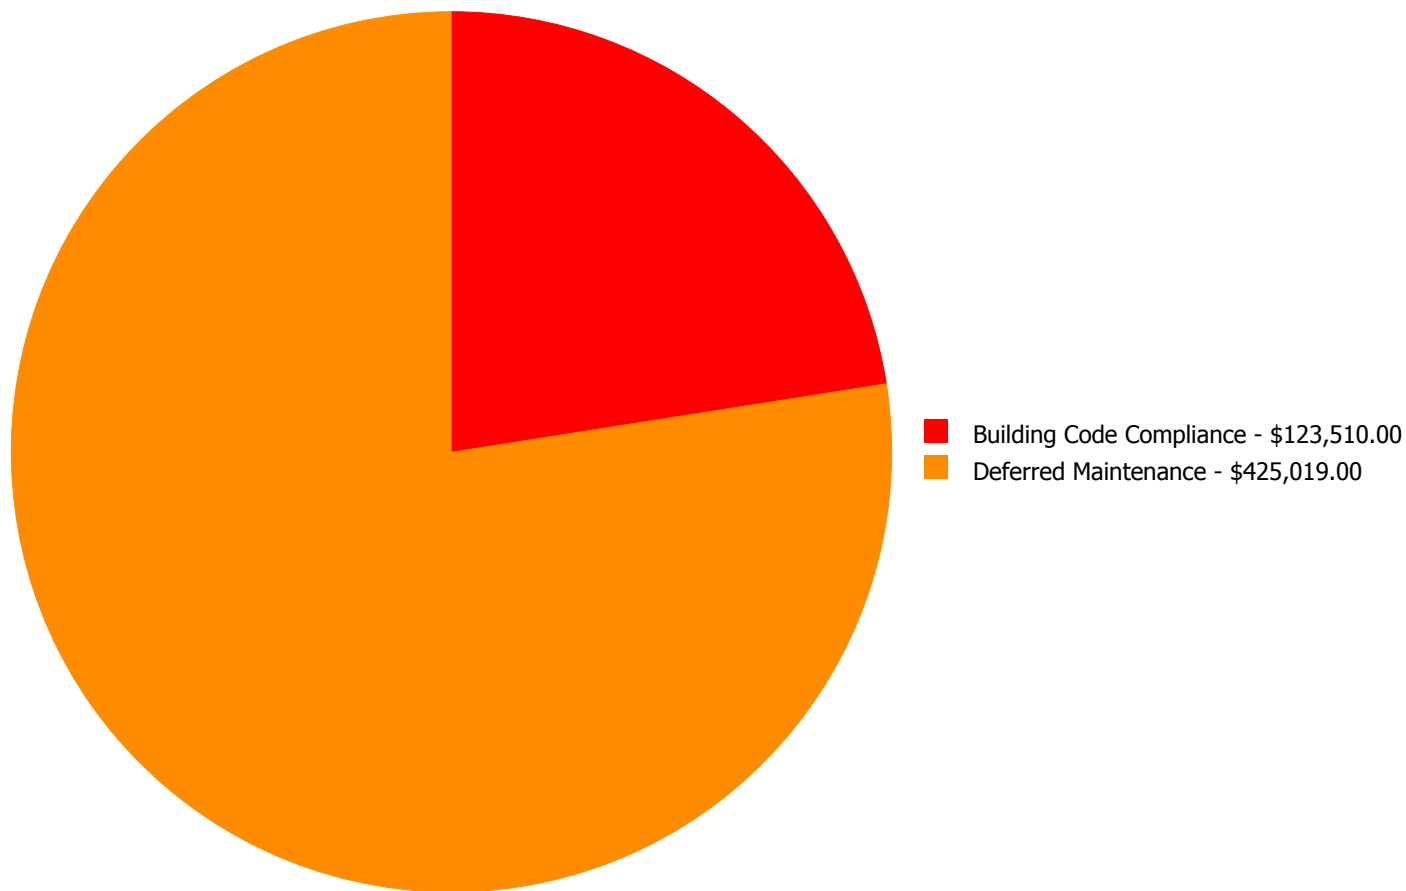
Deficiency Summary by Category

The following chart shows the total repair costs broken down by deficiency categories. Assessors assigned deficiencies to one of the following categories:

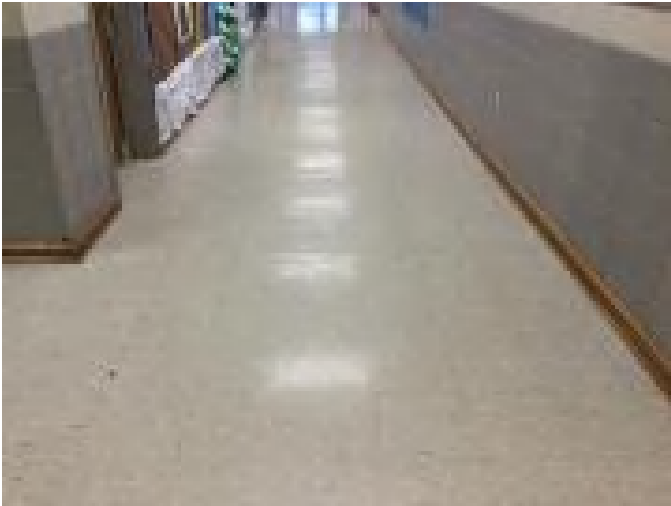
System: C3020 - Floor Finishes

Location: Throughout the building
Distress: Beyond Service Life
Category: Deferred Maintenance
Priority: 4 - Recommended (Years 6-10)
Correction: Renew System
Qty: 22,016.00
Unit of Measure: S.F.
Estimate: \$280,924.00
Assessor Name: Eduardo Lopez
Date Created: 01/18/2017

Notes: The floor covering is aged, damaged in some areas and beyond its service life.

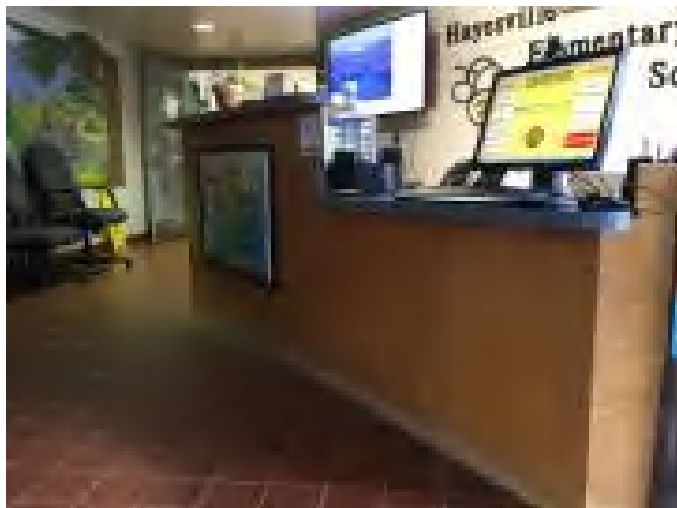
System: E2010 - Fixed Furnishings

Location: Throughout the building
Distress: Beyond Service Life
Category: Deferred Maintenance
Priority: 4 - Recommended (Years 6-10)
Correction: Renew System
Qty: 22,016.00
Unit of Measure: S.F.
Estimate: \$144,095.00
Assessor Name: Eduardo Lopez
Date Created: 01/18/2017

Notes: The fixed furnishings are aged, in marginal condition, and should be replaced.

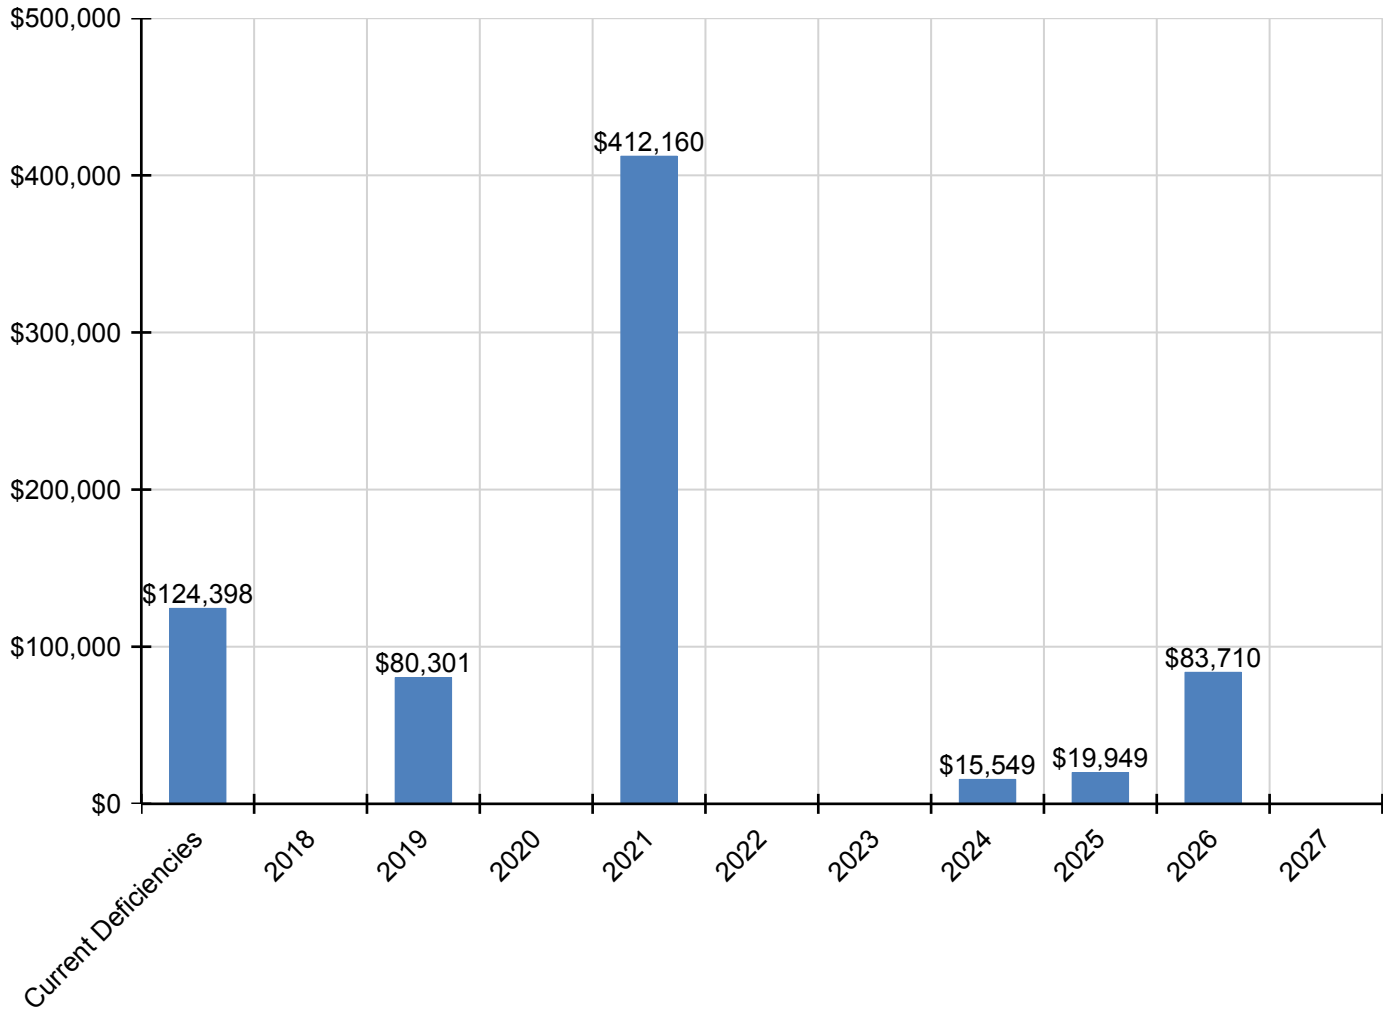
Forecasted Capital Renewal Requirement

The following chart shows the current building deficiencies and forecasting capital renewal or sustainment requirements over the next ten years.
