NC School District/220 Clay County/High School

Hayesville High

Campus Assessment Report

March 7, 2017

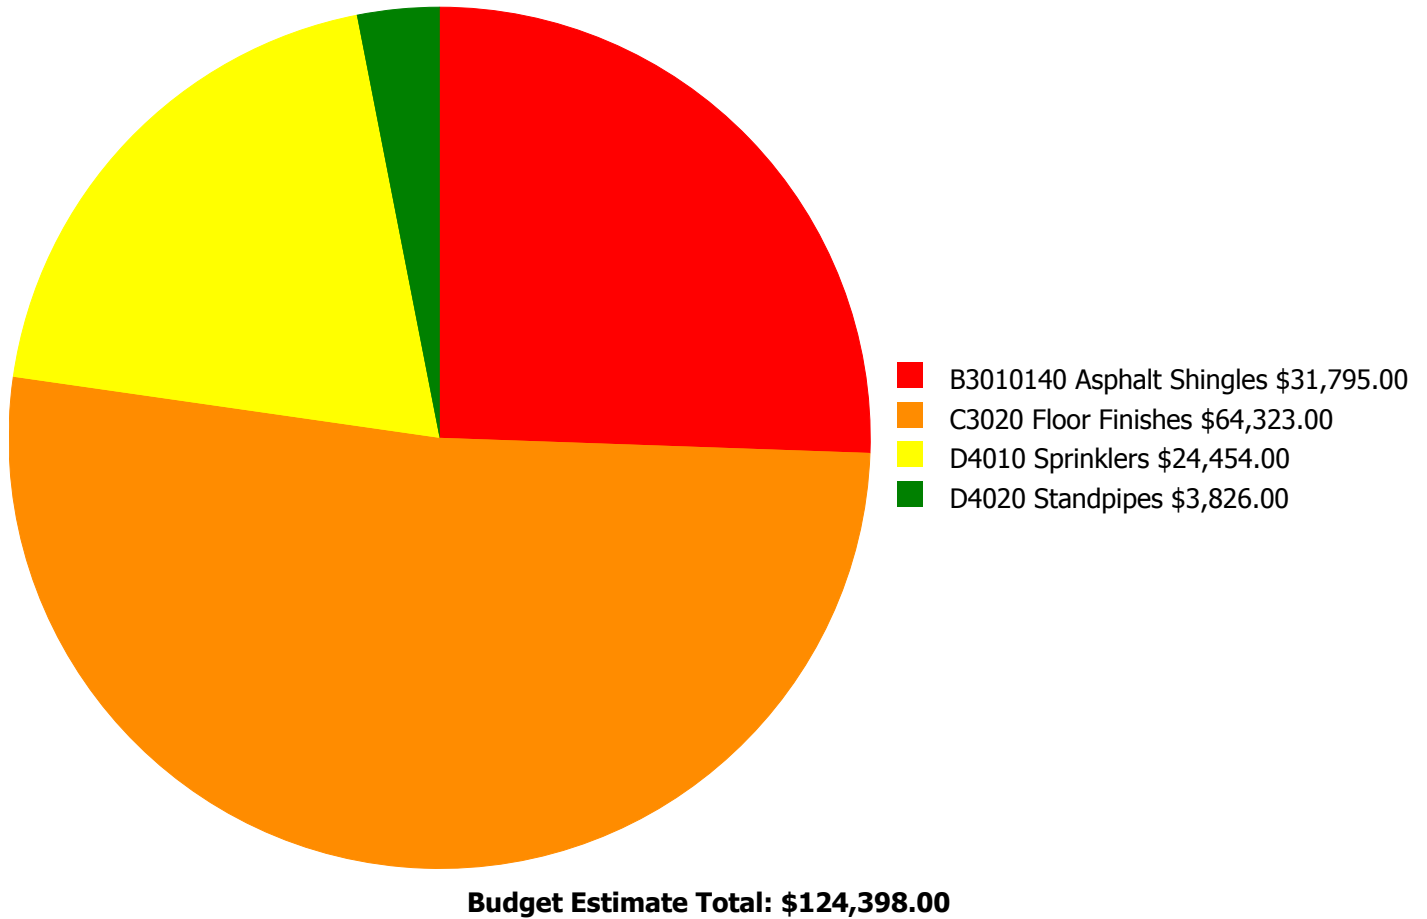
Deficiency Summary by System

Current deficiencies included assemblies that have reached or exceeded their design life or components of the assemblies that are in need of repair. Assemblies that have reached their design life are identified as current deficiencies and assigned the distress 'Beyond Useful Life'. The following chart lists all current deficiencies associated with this facility.

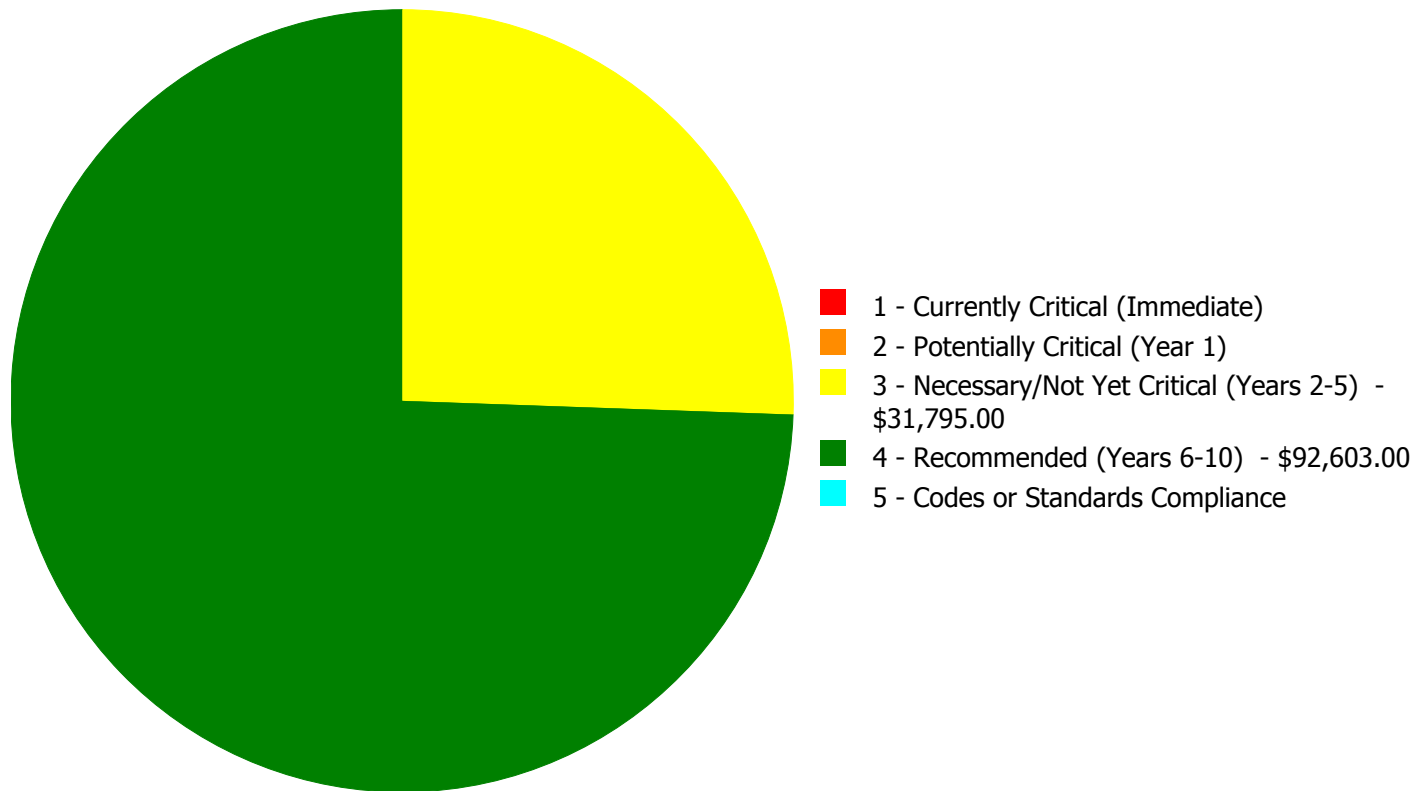
Deficiency Summary by Priority

The following chart shows the total repair costs broken down by priority. Assessors assigned deficiencies within eCOMET to one of the following priority categories:

Budget Estimate Total: \$124,398.00

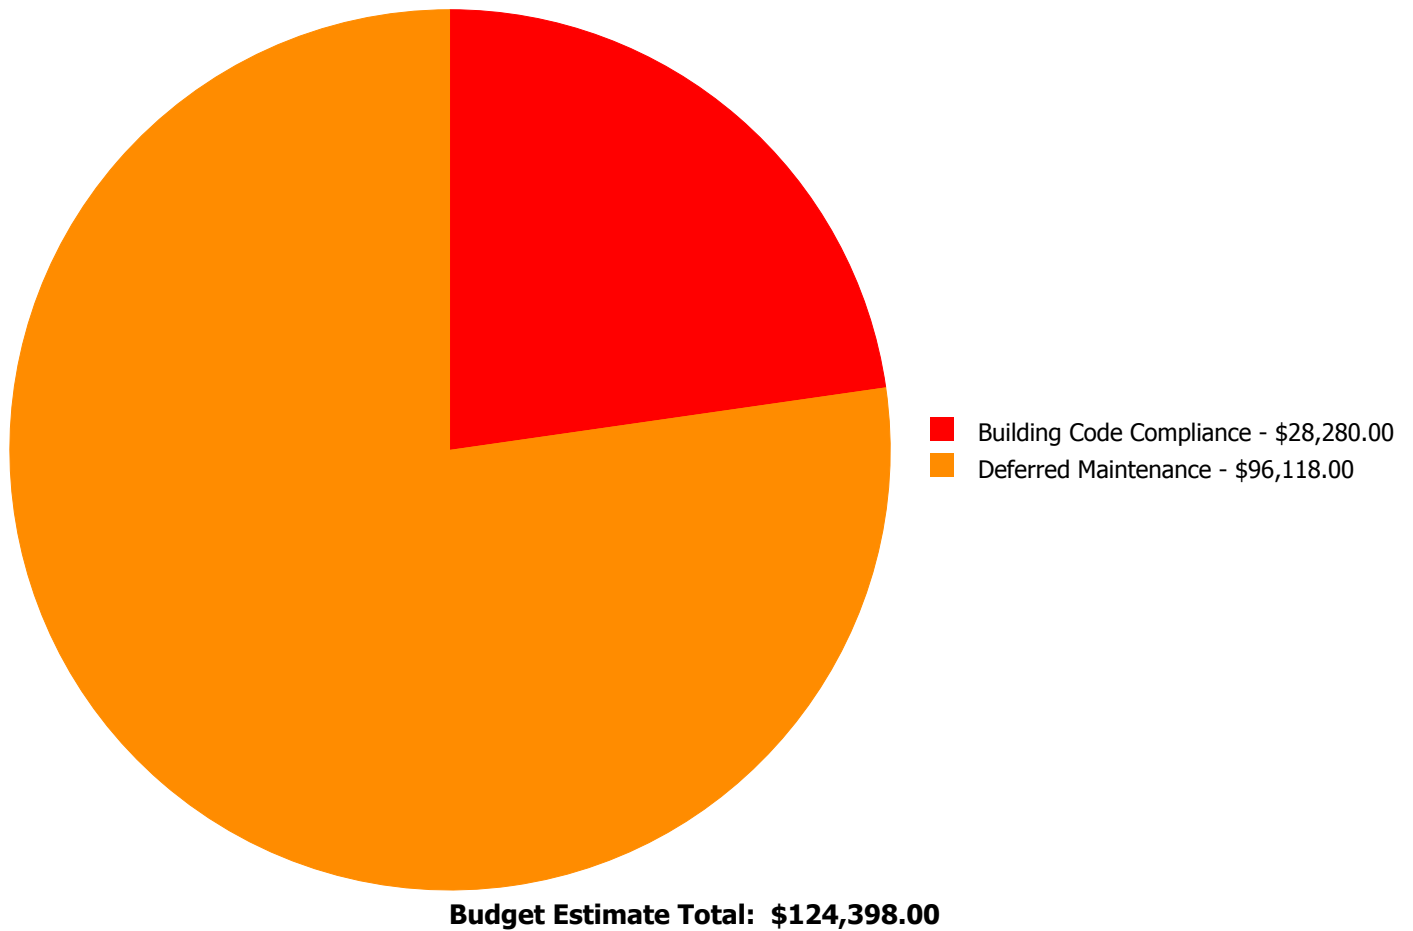
Deficiency Summary by Category

The following chart shows the total repair costs broken down by deficiency categories. Assessors assigned deficiencies to one of the following categories:

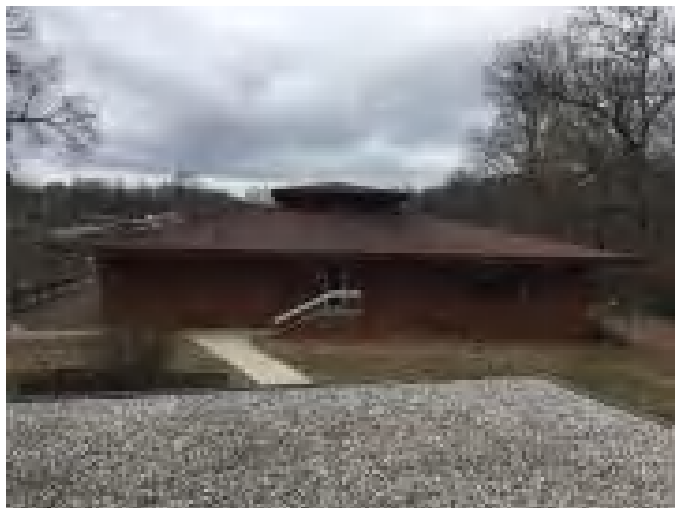
System: B3010140 - Asphalt Shingles

Location: Roof
Distress: Damaged
Category: Deferred Maintenance
Priority: 3 - Necessary/Not Yet Critical (Years 2-5)
Correction: Renew System
Qty: 5,041.00
Unit of Measure: S.F.
Estimate: \$31,795.00
Assessor Name: Eduardo Lopez
Date Created: 01/18/2017

Notes: The asphalt shingle roofing is aged, damaged and should be replaced.

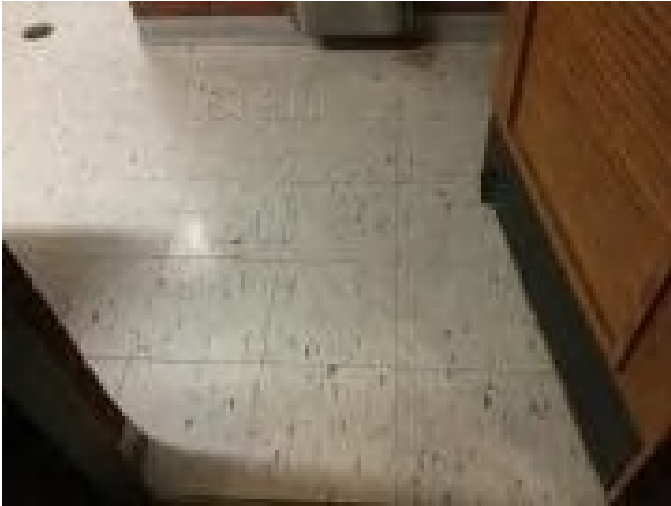
System: C3020 - Floor Finishes

Location: Throughout the building
Distress: Damaged
Category: Deferred Maintenance
Priority: 4 - Recommended (Years 6-10)
Correction: Renew System
Qty: 5,041.00
Unit of Measure: S.F.
Estimate: \$64,323.00
Assessor Name: Eduardo Lopez
Date Created: 01/18/2017

Notes: The floor coverings are beyond their service life, damaged in different areas throughout the building and should be replaced.
