NC School District/300 Davie County/High School

Central Davie Academy

Campus Assessment Report

March 7, 2017

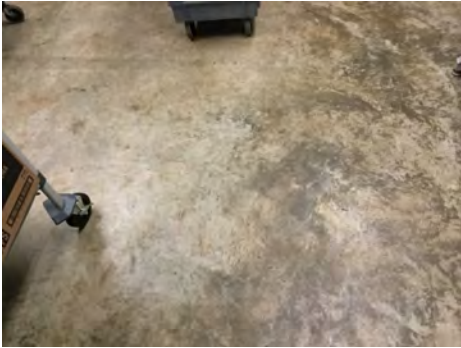
System: A1030 - Slab on Grade

The main building rests on standard cast-in-place concrete foundations. The building has a partial basement that was used as a boiler room. The original main building has a crawlspace. The kitchen addition has slab-on-grade construction.

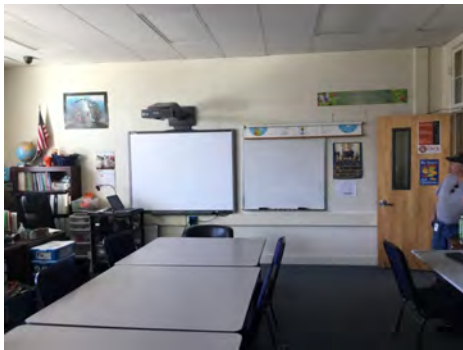
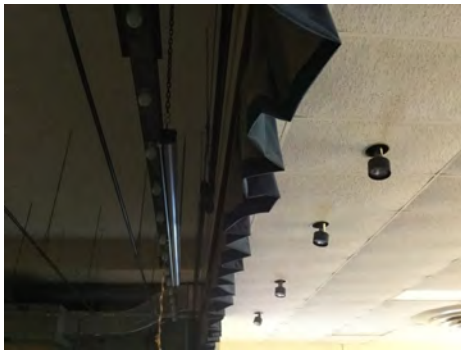
System: E1020 - Institutional Equipment

Note: Smartboards are up to date. Auditorium seating is old, but in well maintained condition. Year installed date set to 2004.

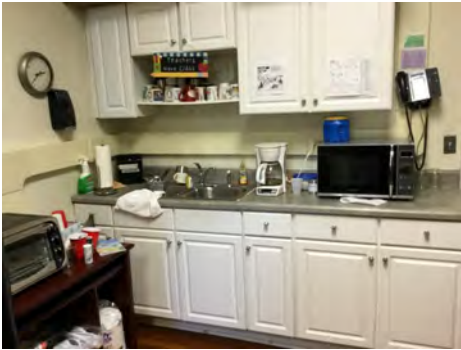
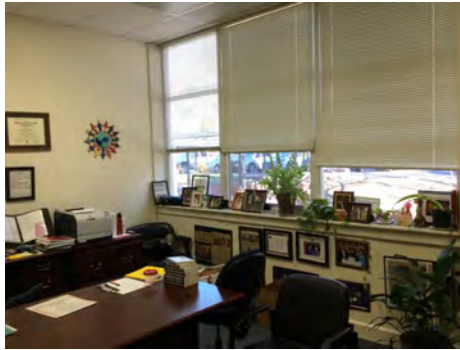
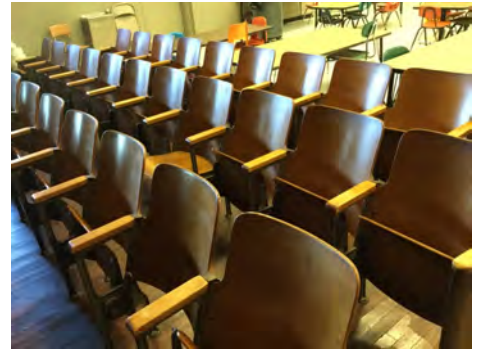
System: E2010 - Fixed Furnishings

Note: Auditorium seating is old, but well maintained.

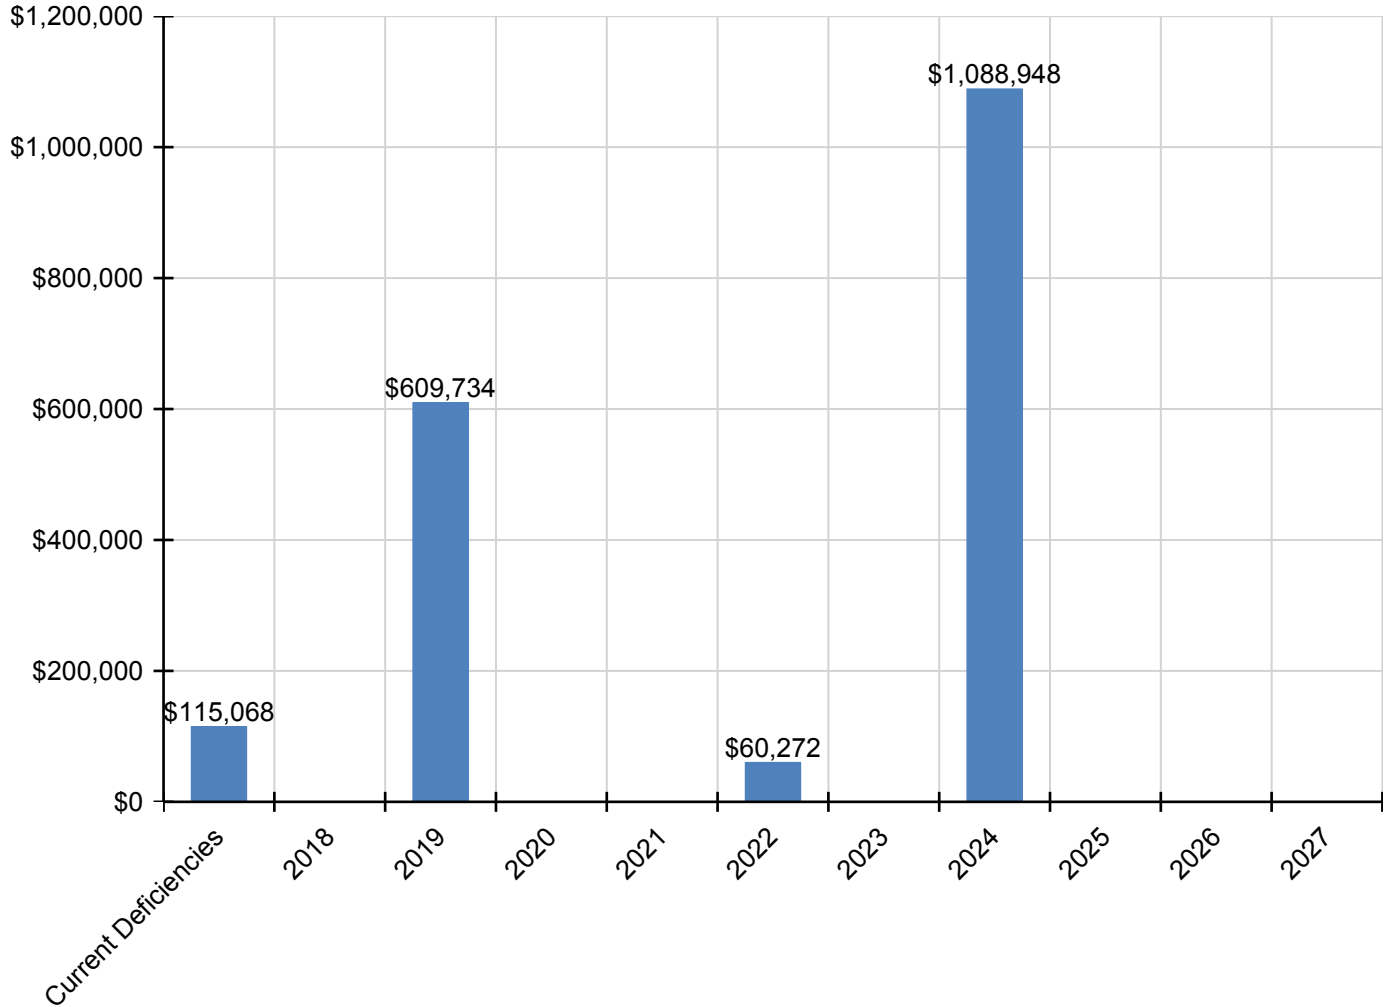
Forecasted Capital Renewal Requirement

The following chart shows the current building deficiencies and forecasting capital renewal or sustainment requirements over the next ten years.

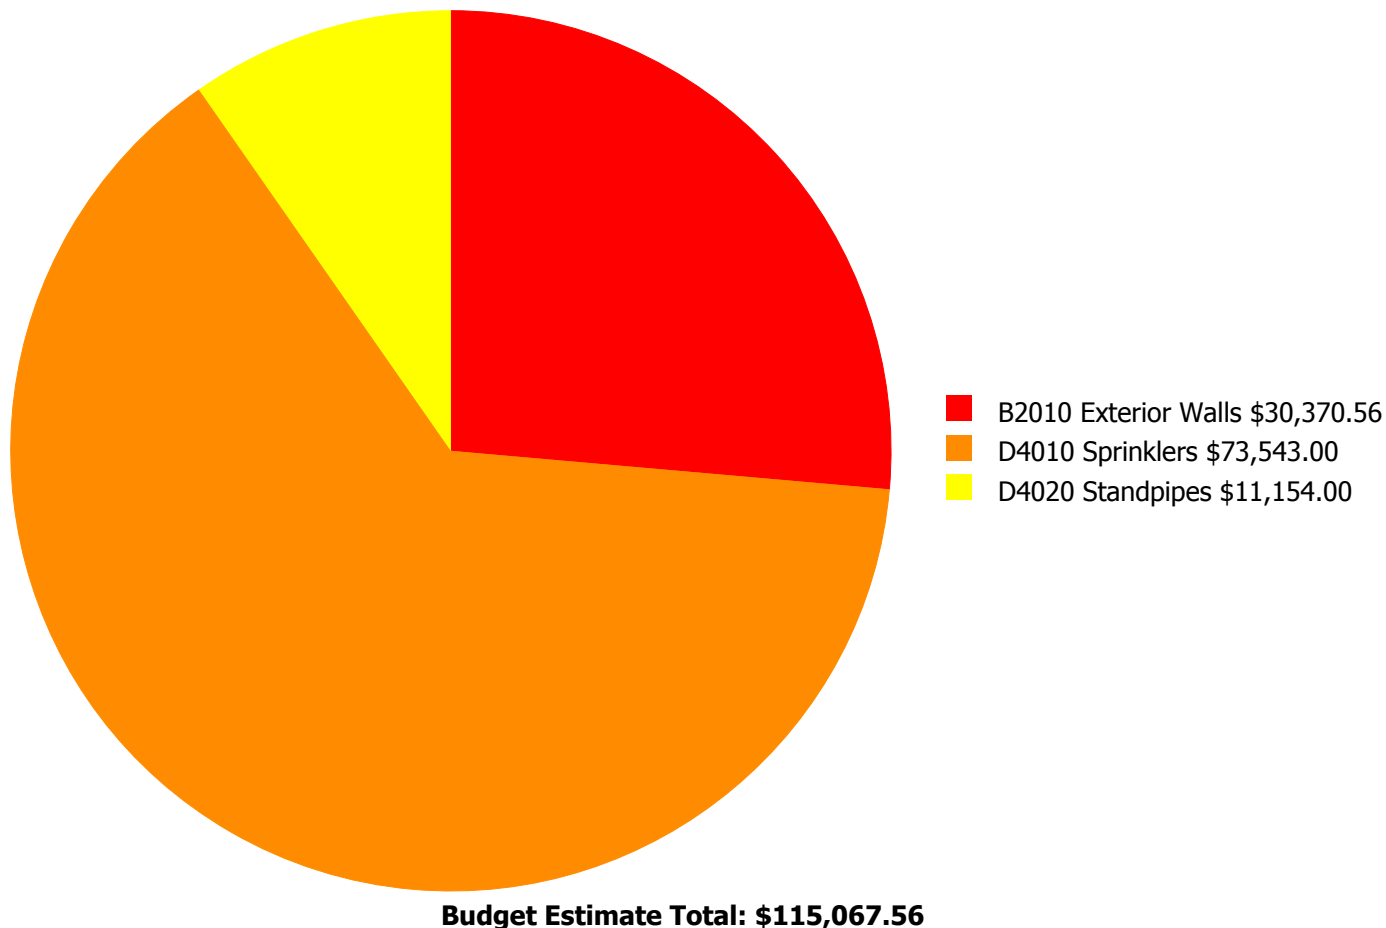
Deficiency Summary by System

Current deficiencies included assemblies that have reached or exceeded their design life or components of the assemblies that are in need of repair. Assemblies that have reached their design life are identified as current deficiencies and assigned the distress 'Beyond Useful Life'. The following chart lists all current deficiencies associated with this facility.

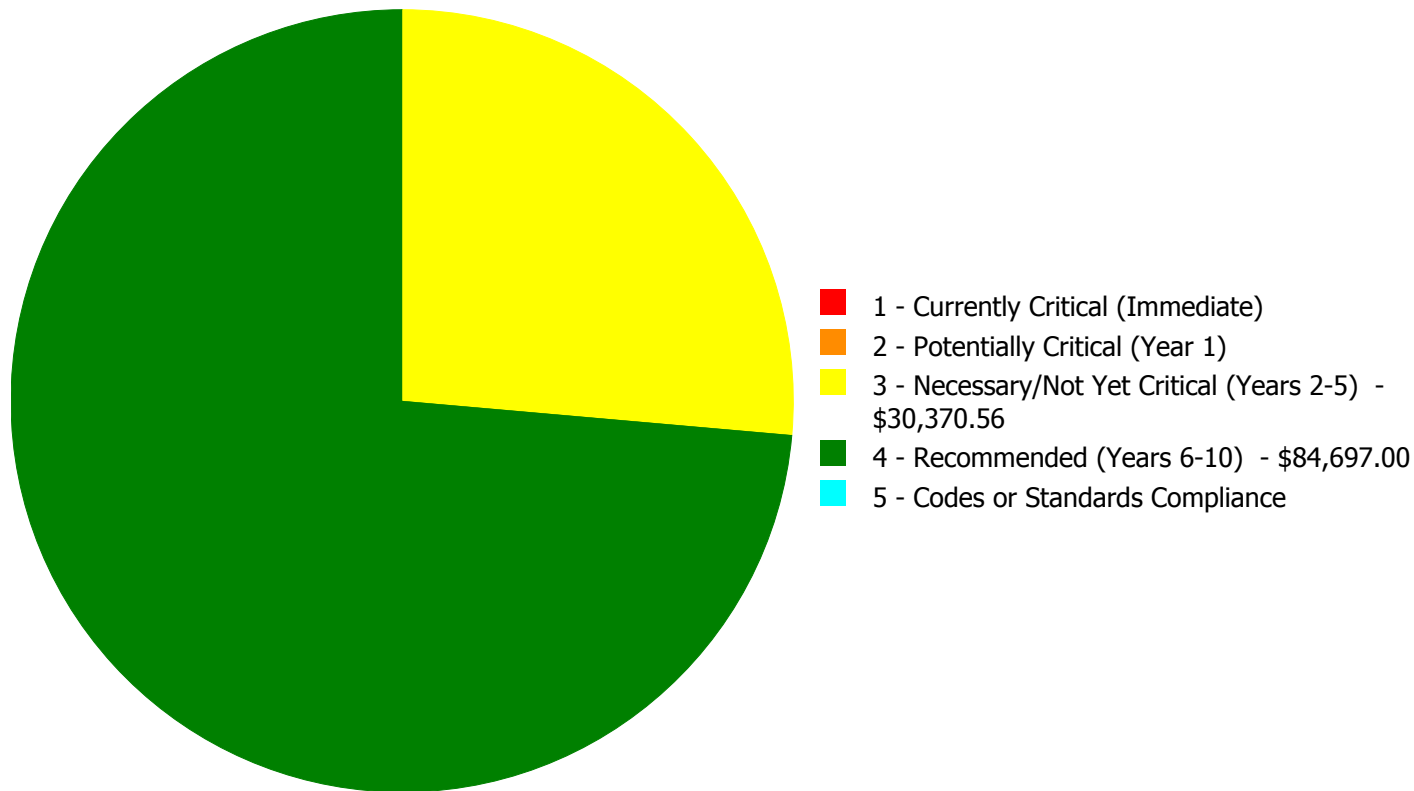
Deficiency Summary by Priority

The following chart shows the total repair costs broken down by priority. Assessors assigned deficiencies within eCOMET to one of the following priority categories:

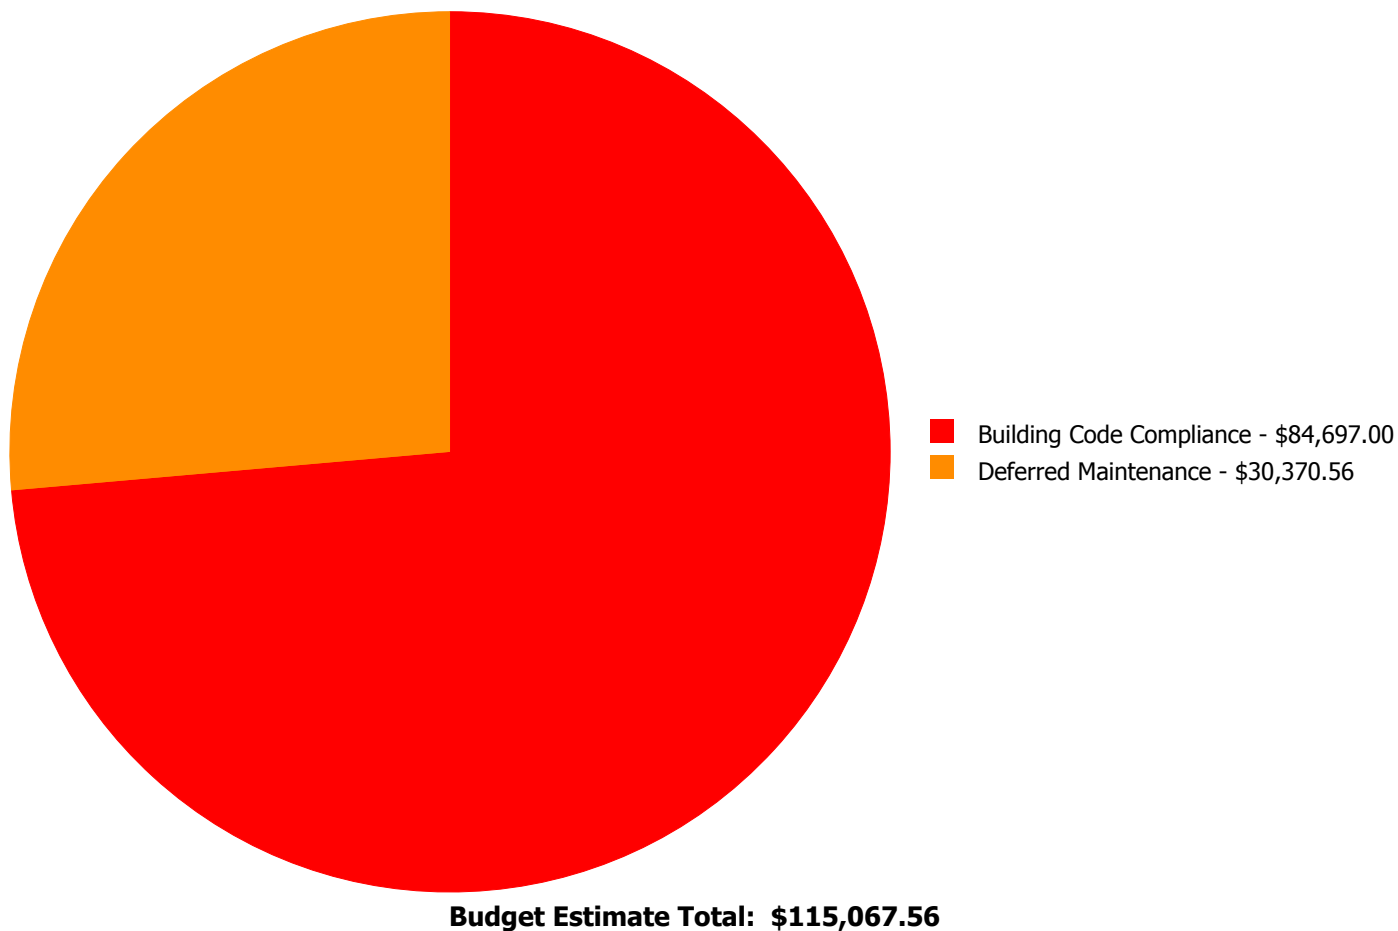
Deficiency Summary by Category

The following chart shows the total repair costs broken down by deficiency categories. Assessors assigned deficiencies to one of the following categories:

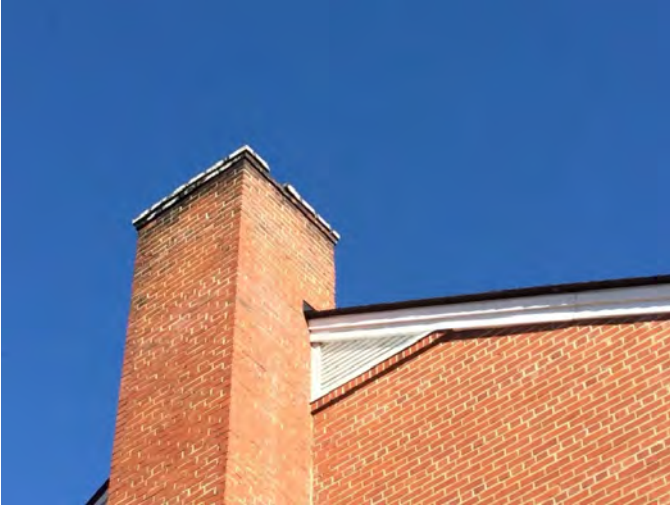
System: B2010 - Exterior Walls

Location: West wall, chimney
Distress: Damaged
Category: Deferred Maintenance
Priority: 3 - Necessary/Not Yet Critical (Years 2-5)
Correction: Point clay brick wall, 2nd floor
Qty: 12.00
Unit of Measure: C.S.F.
Estimate: \$17,170.56
Assessor Name: Eduardo Lopez
Date Created: 02/18/2017

Notes: Some pointing/repair of brick is recommended. Chimney top is deteriorating.

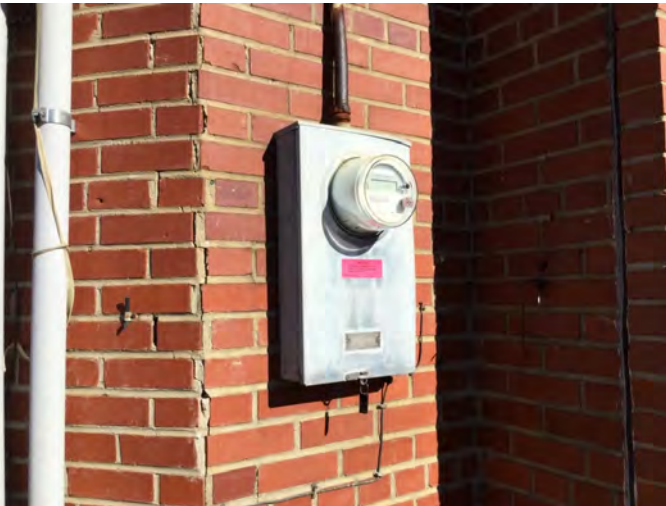
System: B2010 - Exterior Walls

Location: South, east end of building
Distress: Failing
Category: Deferred Maintenance
Priority: 3 - Necessary/Not Yet Critical (Years 2-5)
Correction: Engineering Study-2016-11-15 17:41:59
Qty: 1.00
Unit of Measure: Ea.
Estimate: \$13,200.00
Assessor Name: Eduardo Lopez
Date Created: 02/18/2017

Notes: Some settlement cracking is observed. An Engineering study to determine the seriousness of the condition is recommended.

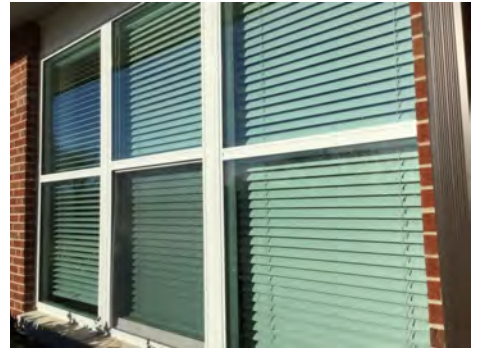
System: B2020 - Exterior Windows

Note: New windows designed with removable panel to readily accommodate new wall mounted heat pumps to be installed summer 2017.

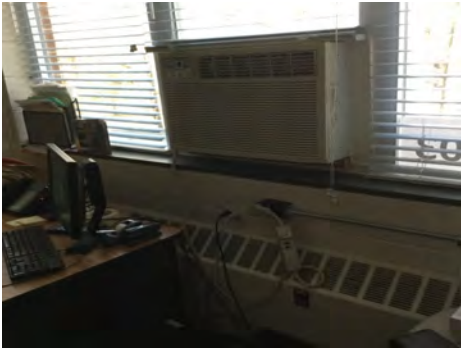
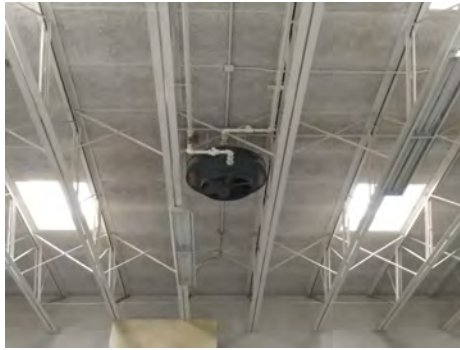
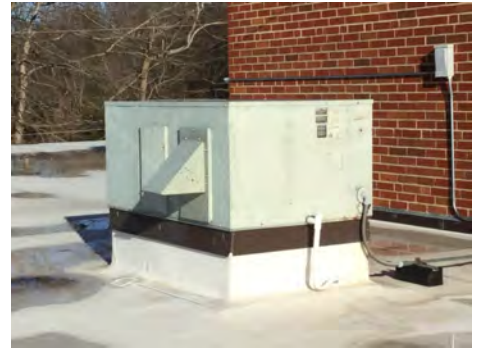
System: D3050 - Terminal & Package Units

Note: Wall mounted heat pumps being installed Summer 2017.

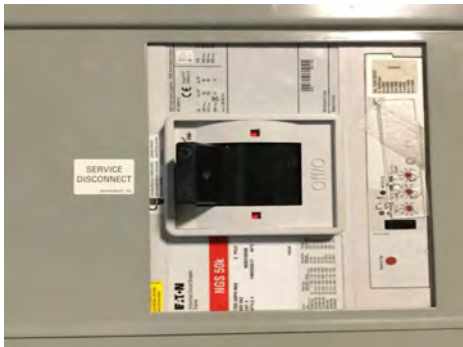
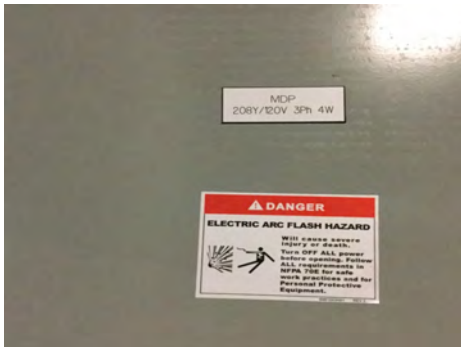
System: D5010 - Electrical Service/Distribution

Note: Upgrades to electric service made to accommodate HVAC change to window mounted heat pumps.

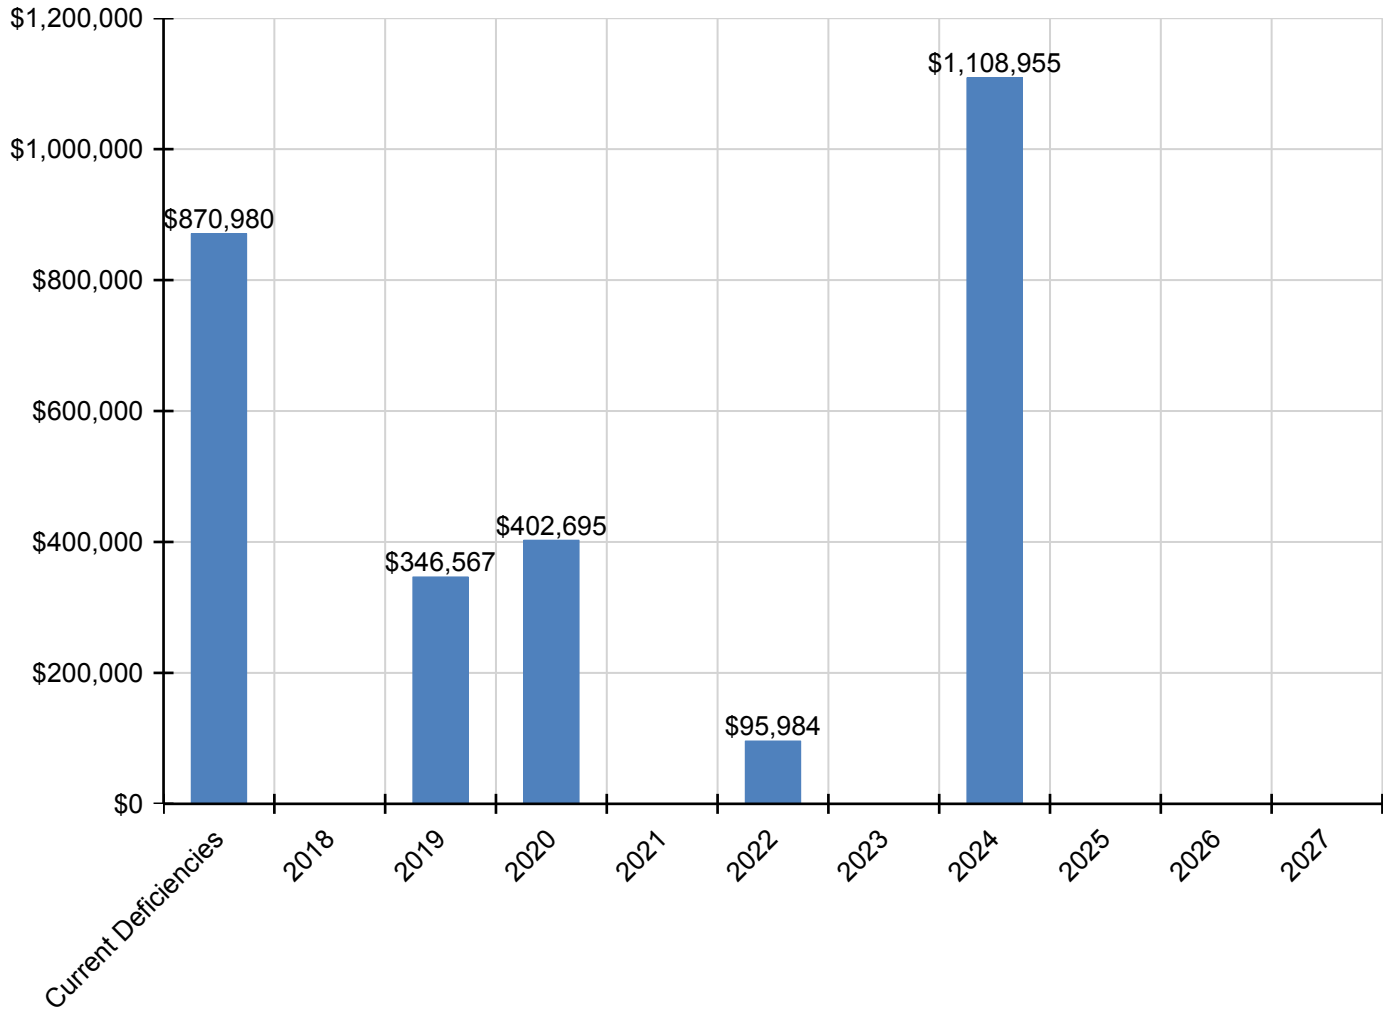
Forecasted Capital Renewal Requirement

The following chart shows the current building deficiencies and forecasting capital renewal or sustainment requirements over the next ten years.

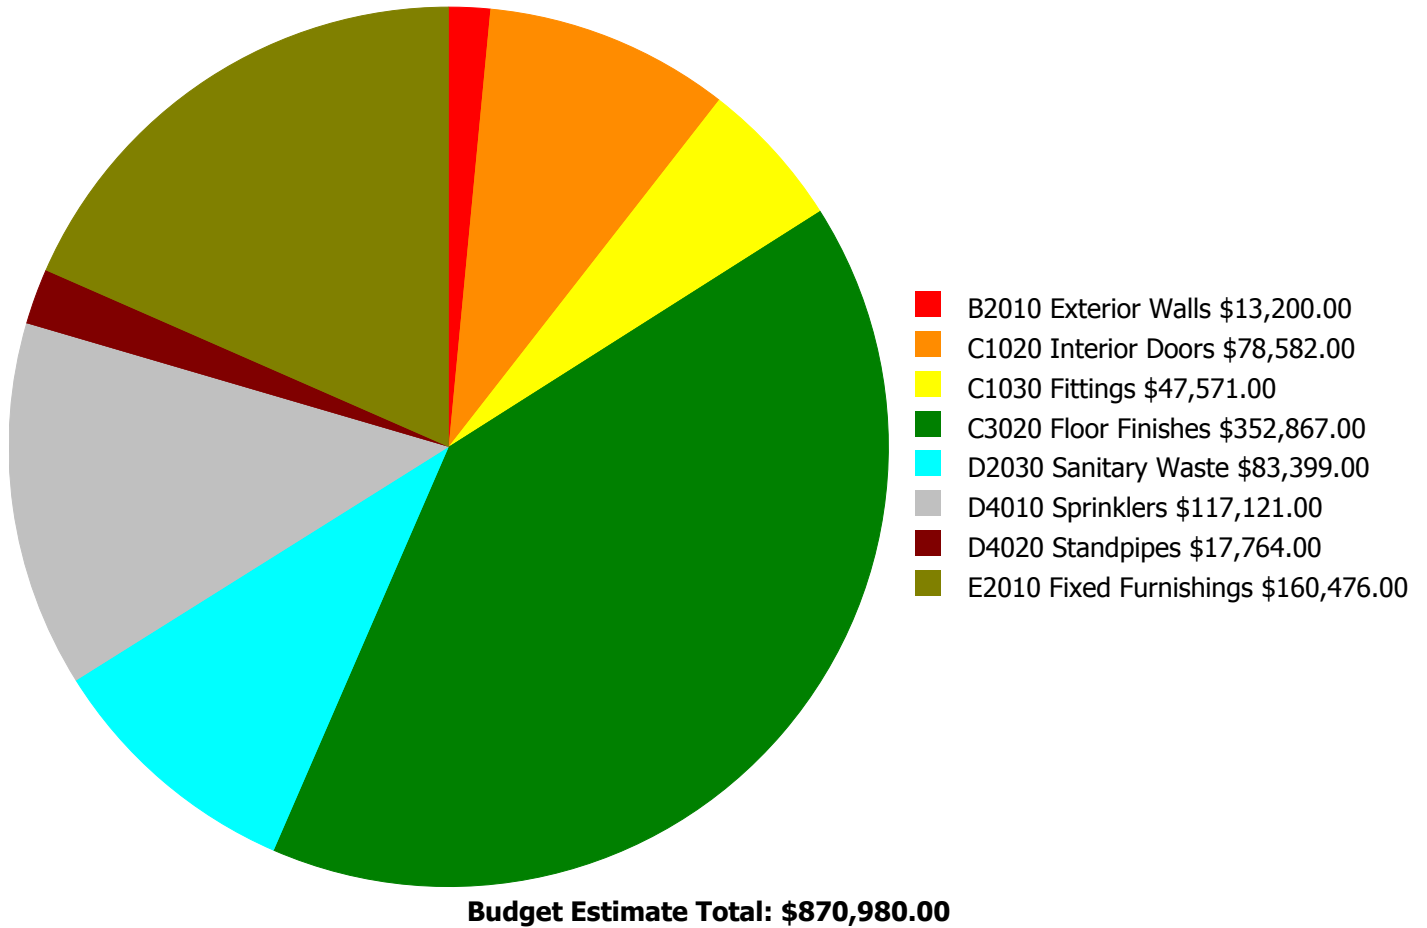
Deficiency Summary by System

Current deficiencies included assemblies that have reached or exceeded their design life or components of the assemblies that are in need of repair. Assemblies that have reached their design life are identified as current deficiencies and assigned the distress 'Beyond Useful Life'. The following chart lists all current deficiencies associated with this facility.

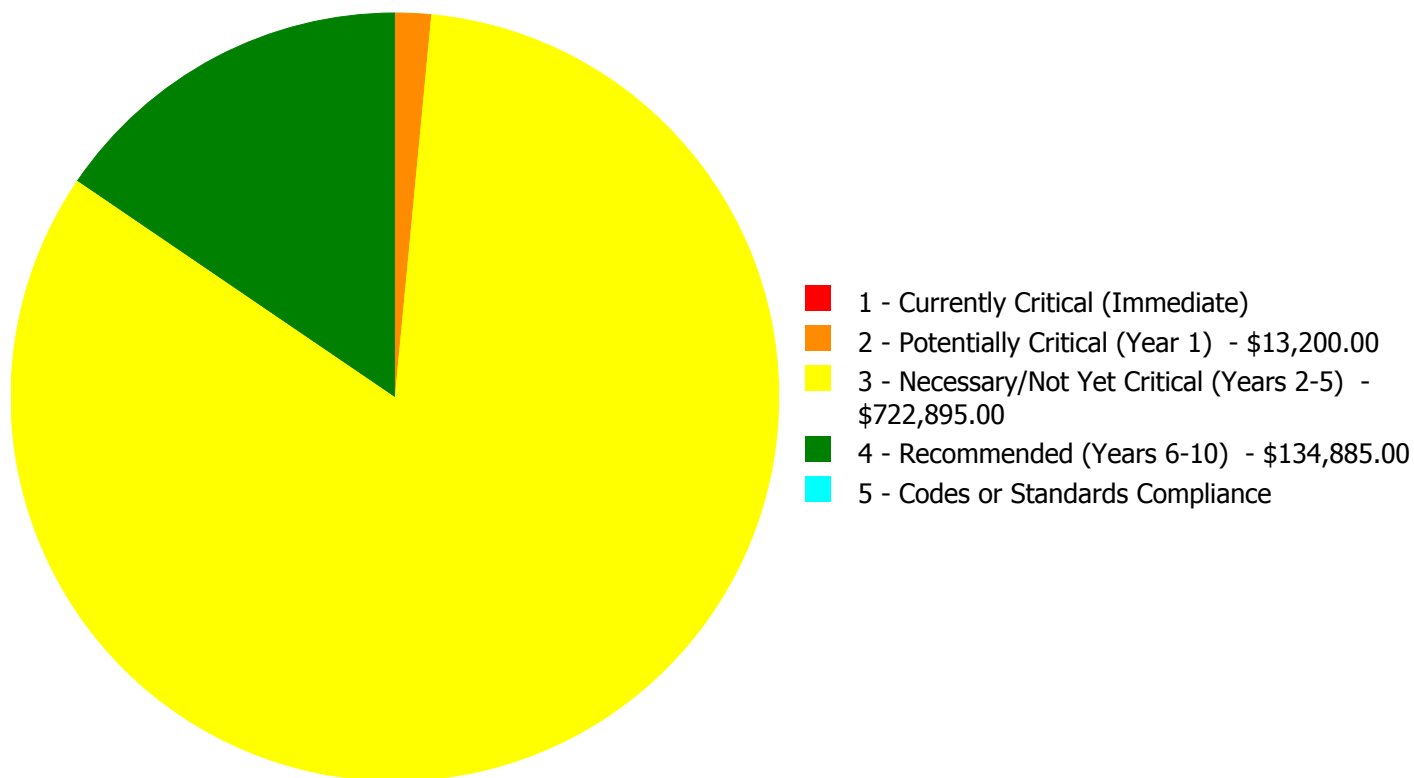
Deficiency Summary by Priority

The following chart shows the total repair costs broken down by priority. Assessors assigned deficiencies within eCOMET to one of the following priority categories:

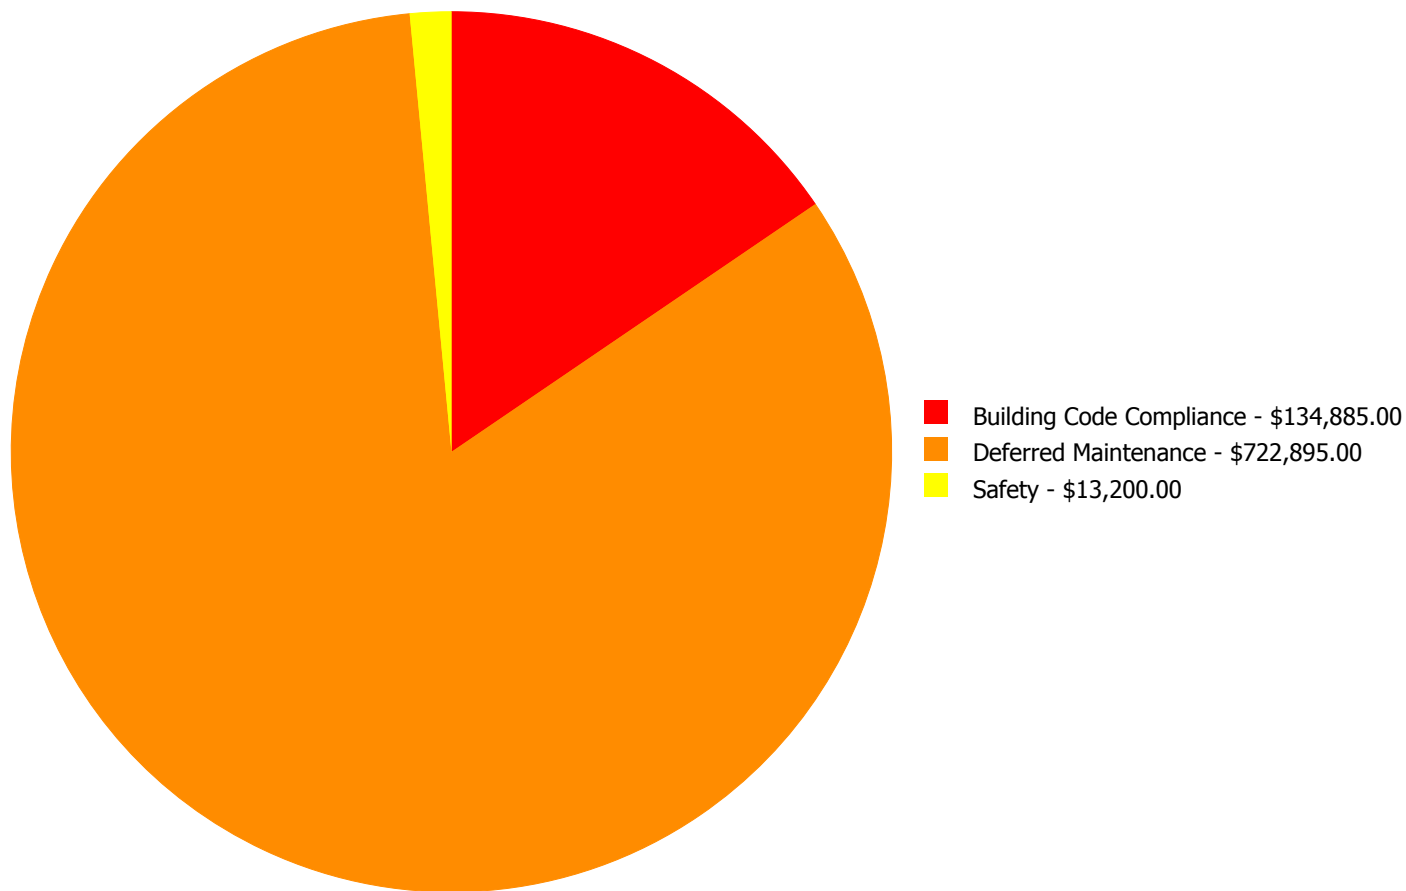
Deficiency Summary by Category

The following chart shows the total repair costs broken down by deficiency categories. Assessors assigned deficiencies to one of the following categories:

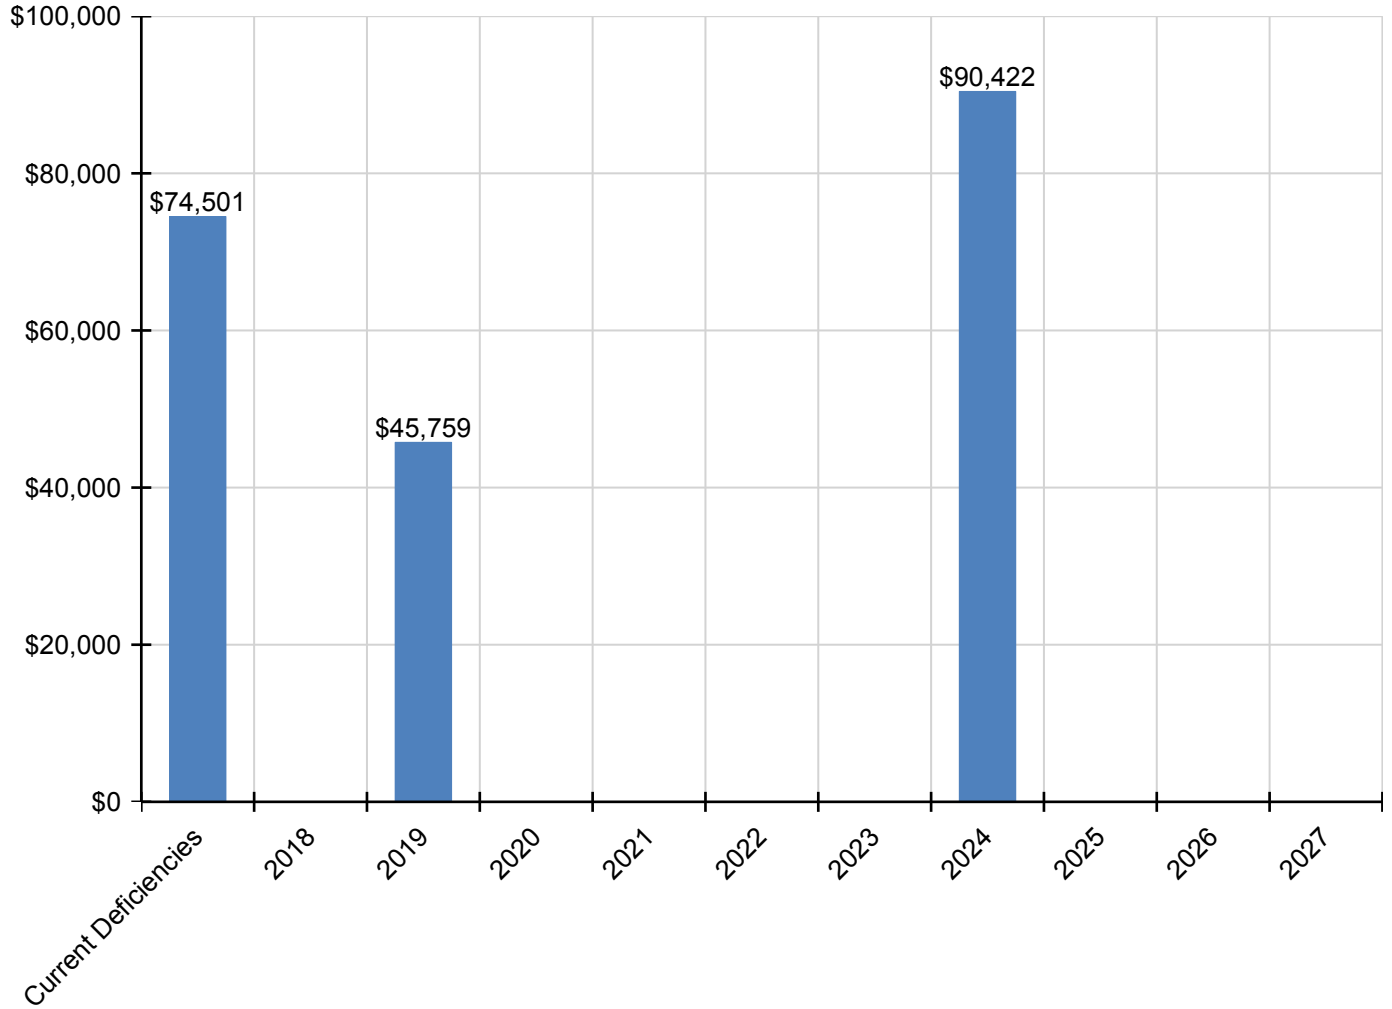
Forecasted Capital Renewal Requirement

The following chart shows the current building deficiencies and forecasting capital renewal or sustainment requirements over the next ten years.

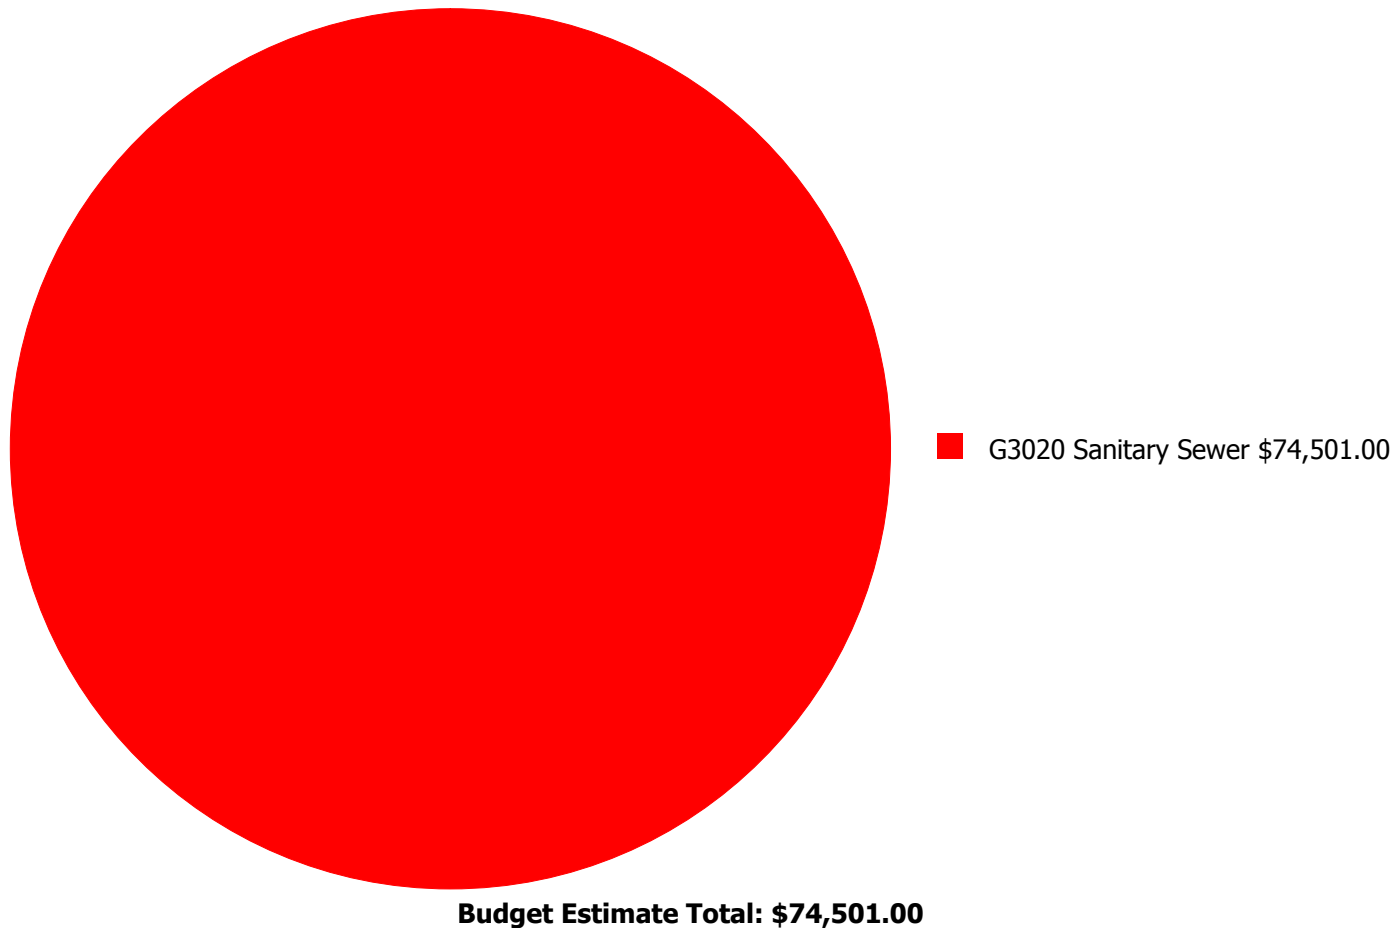
Deficiency Summary by System

Current deficiencies included assemblies that have reached or exceeded their design life or components of the assemblies that are in need of repair. Assemblies that have reached their design life are identified as current deficiencies and assigned the distress 'Beyond Useful Life'. The following chart lists all current deficiencies associated with this facility.

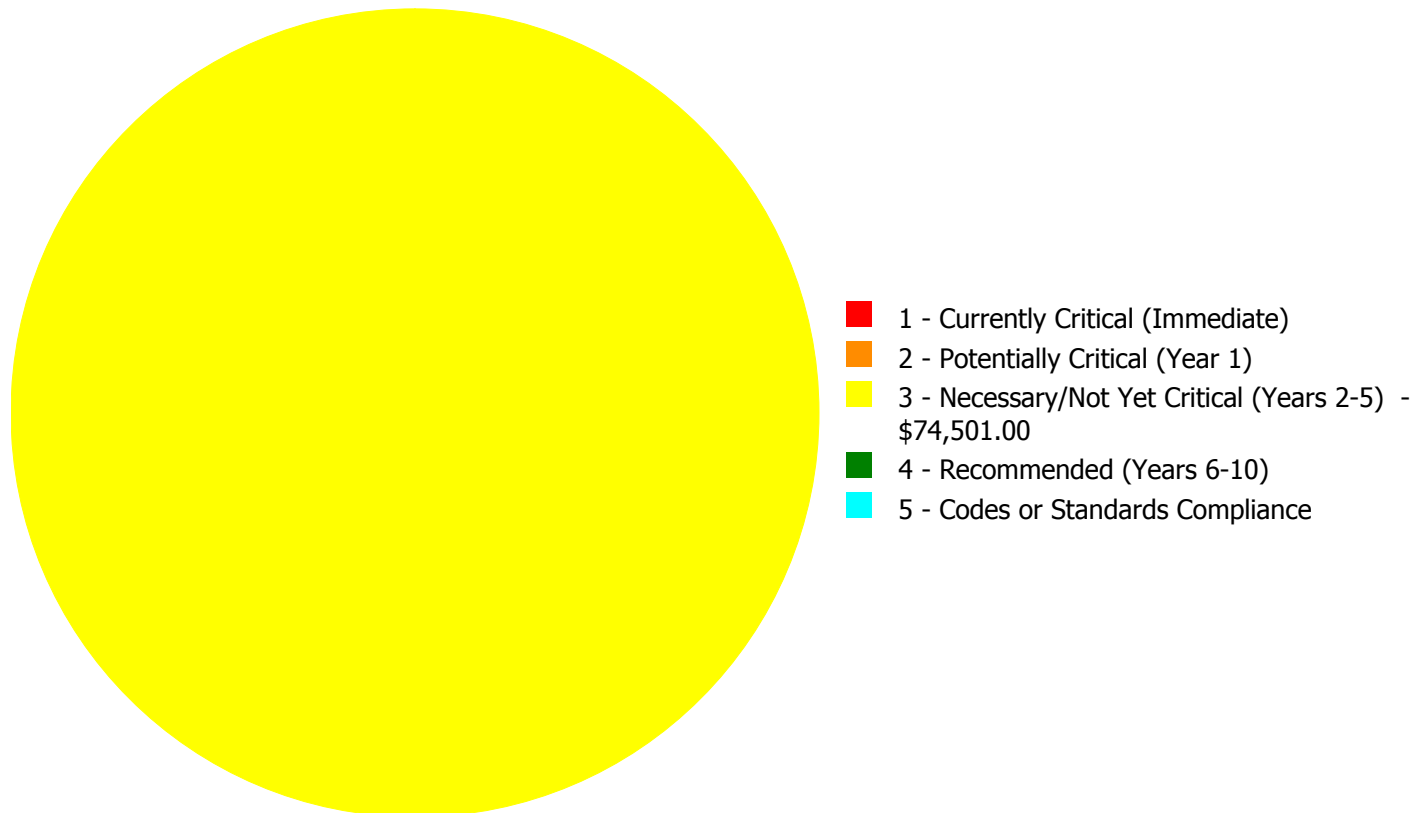
Deficiency Summary by Priority

The following chart shows the total repair costs broken down by priority. Assessors assigned deficiencies within eCOMET to one of the following priority categories:

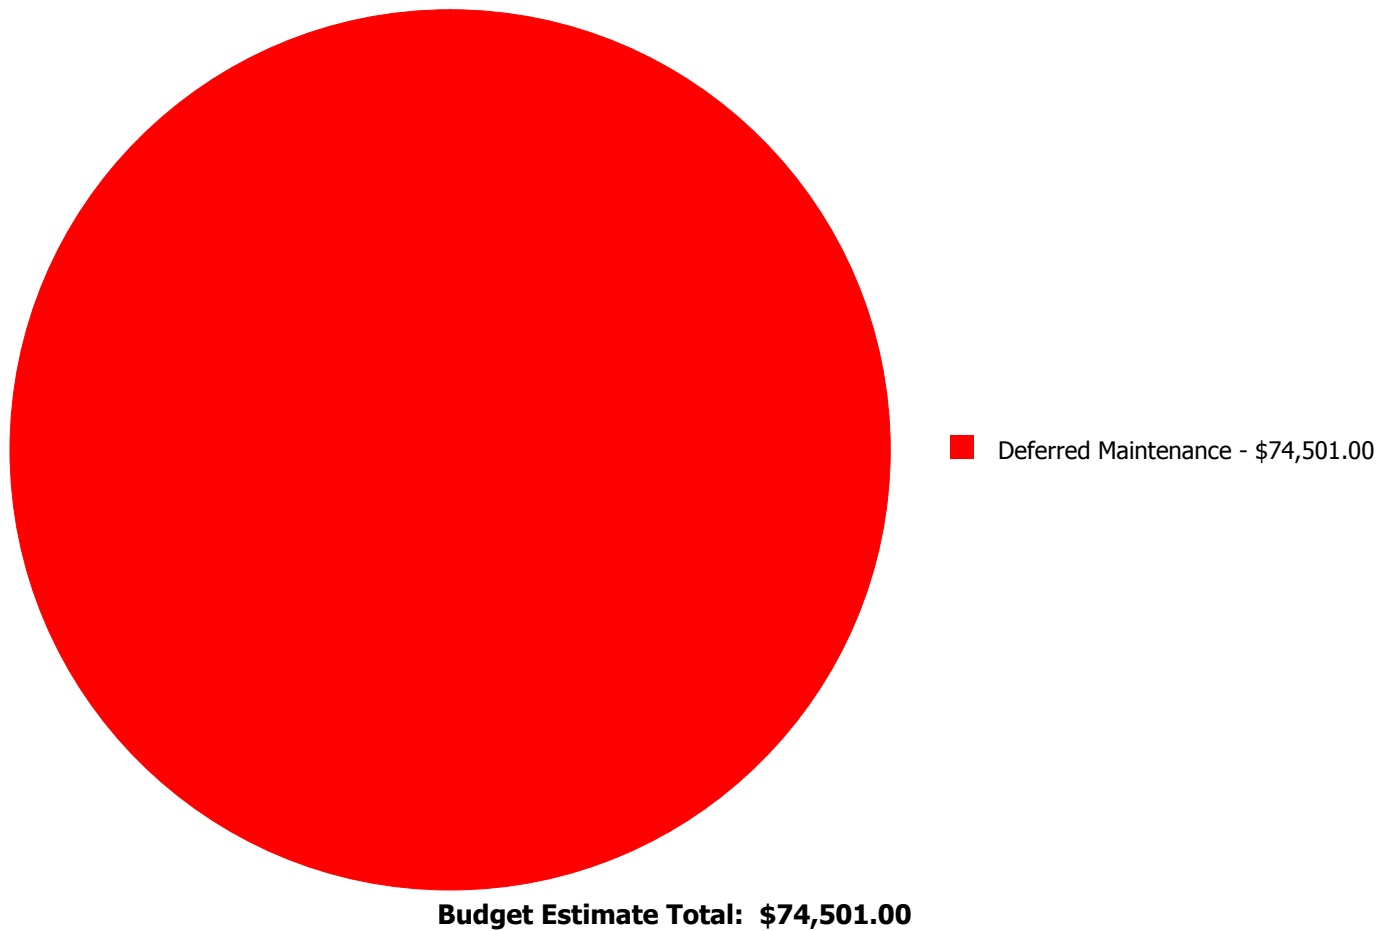
Deficiency Summary by Category

The following chart shows the total repair costs broken down by deficiency categories. Assessors assigned deficiencies to one of the following categories:

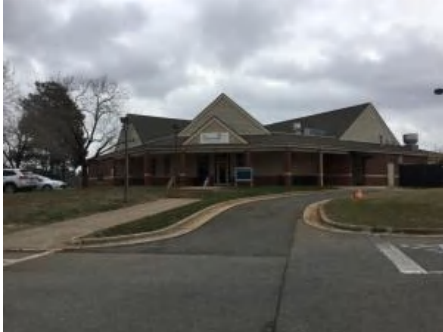
1). Southwest and Northwest Elevations - Feb 14, 2017

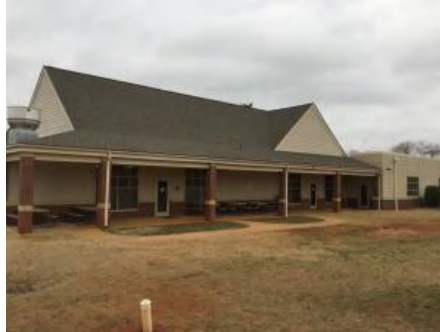
2). Southeast Elevation - Feb 14, 2017

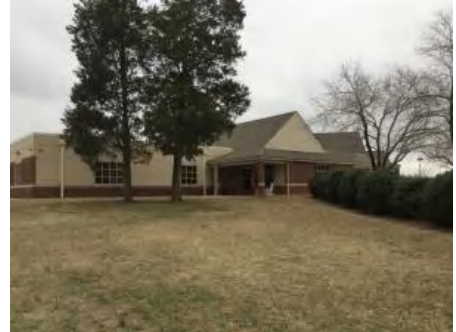
3). Northwest Elevation - Feb 14, 2017

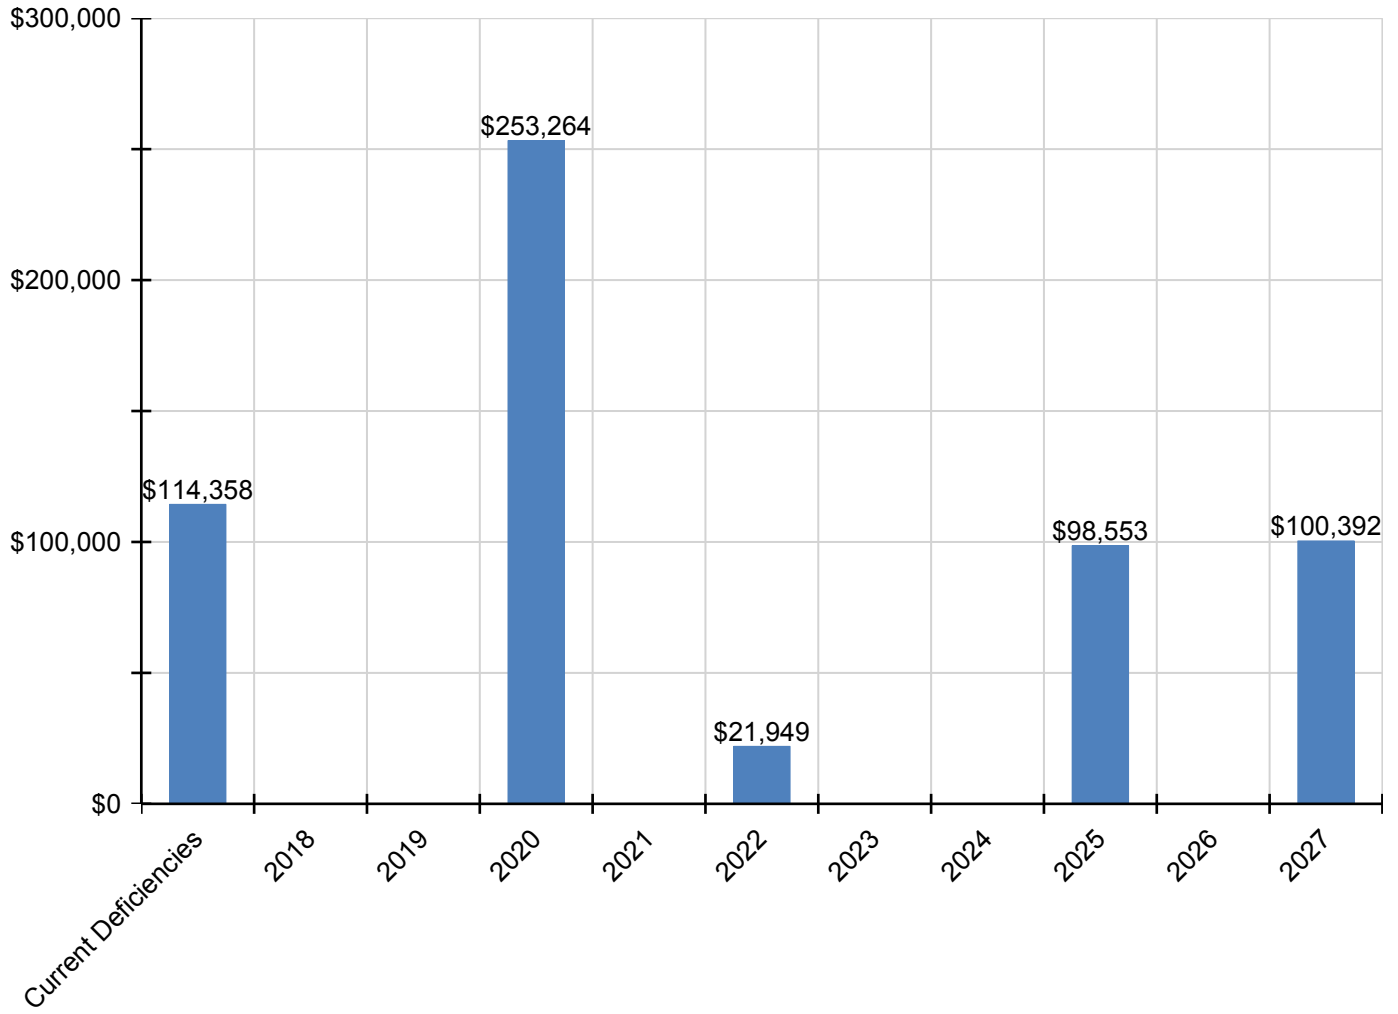
Forecasted Capital Renewal Requirement

The following chart shows the current building deficiencies and forecasting capital renewal or sustainment requirements over the next ten years.

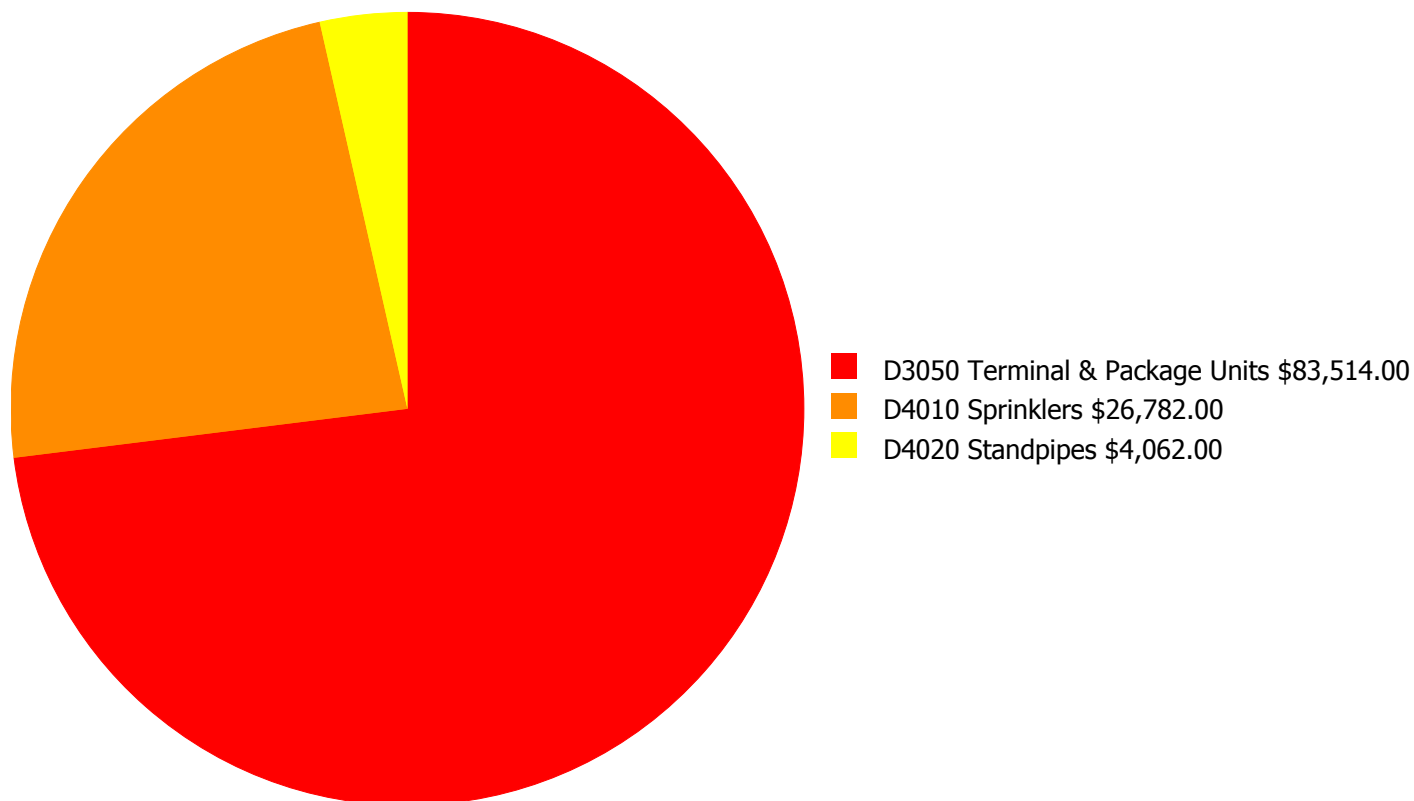
Deficiency Summary by System

Current deficiencies included assemblies that have reached or exceeded their design life or components of the assemblies that are in need of repair. Assemblies that have reached their design life are identified as current deficiencies and assigned the distress 'Beyond Useful Life'. The following chart lists all current deficiencies associated with this facility.
