NC School District/300 Davie County/High School

Central Davie Academy

Campus Assessment Report

March 7, 2017

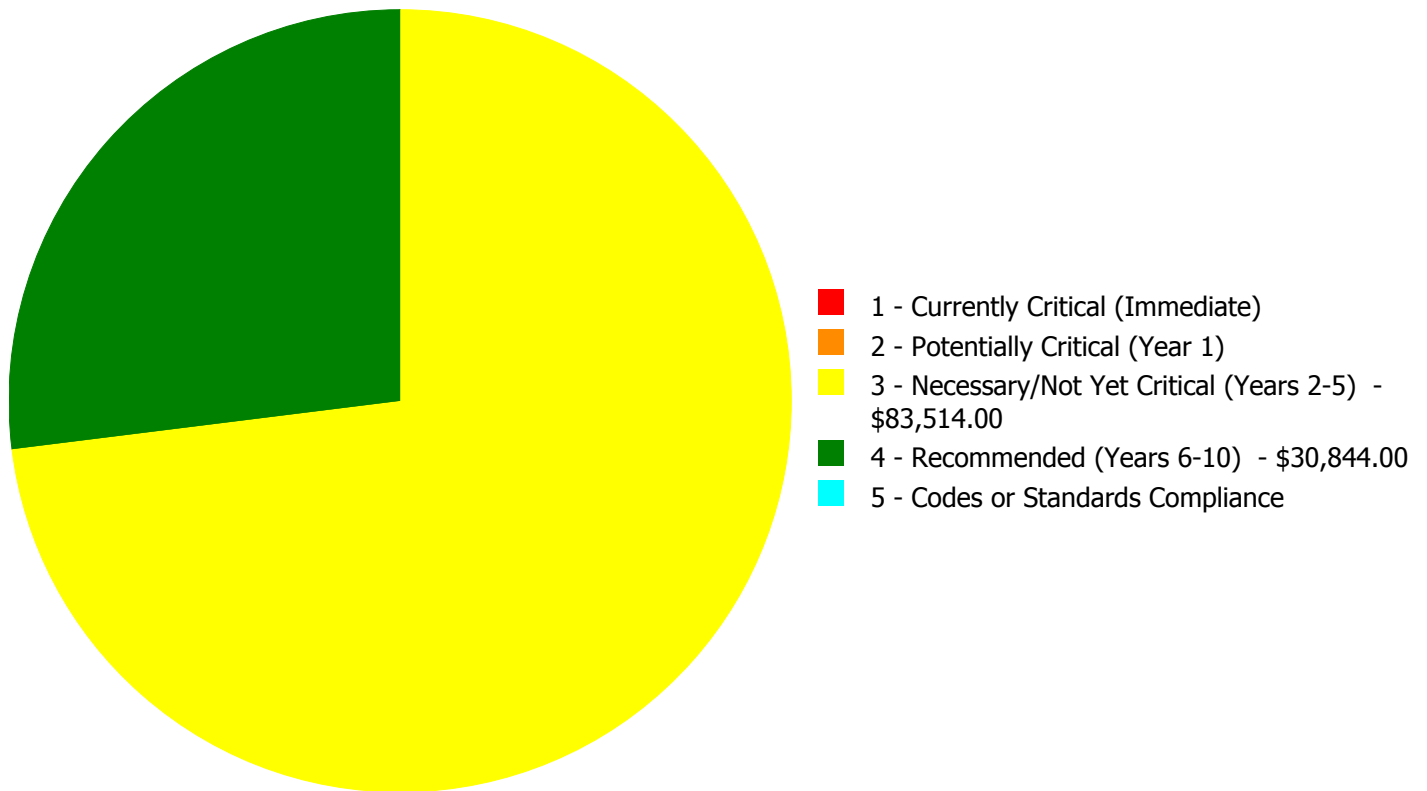
Deficiency Summary by Priority

The following chart shows the total repair costs broken down by priority. Assessors assigned deficiencies within eCOMET to one of the following priority categories:

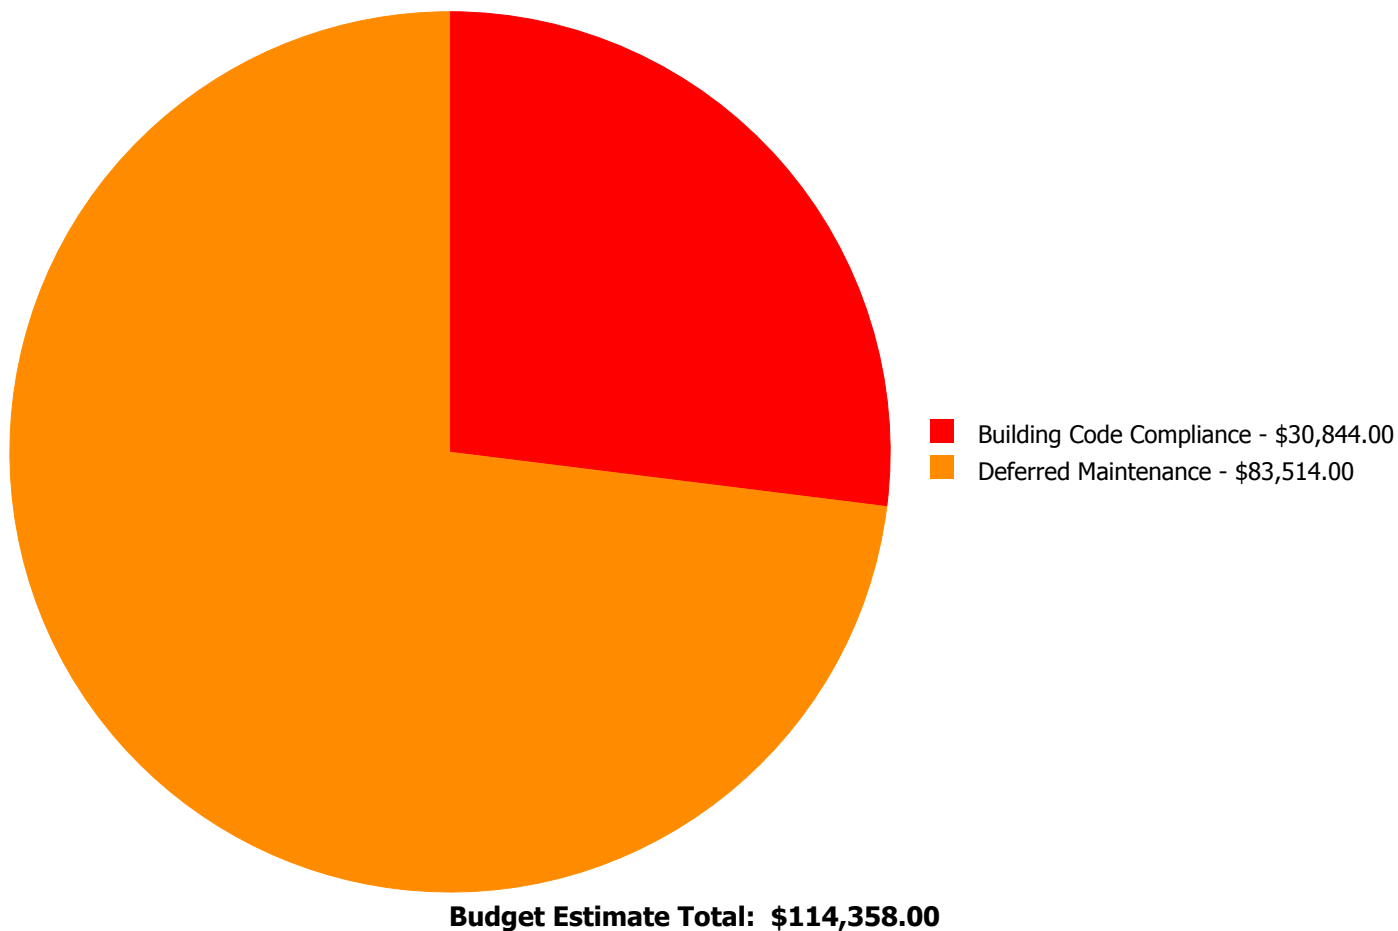
Deficiency Summary by Category

The following chart shows the total repair costs broken down by deficiency categories. Assessors assigned deficiencies to one of the following categories:

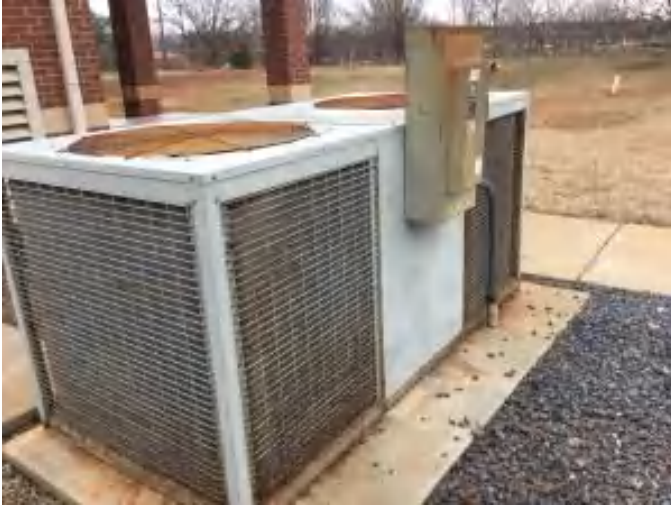
System: D3050 - Terminal & Package Units

Location: Southwest side of building
Distress: Beyond Service Life
Category: Deferred Maintenance
Priority: 3 - Necessary/Not Yet Critical (Years 2-5)
Correction: Renew System
Qty: 6,259.00
Unit of Measure: S.F.
Estimate: \$83,514.00
Assessor Name: Ann Buerger Linden
Date Created: 02/14/2017

Notes: The ground mounted compressor unit for this building is beyond its expected life. System renewal to ensure system performance and for energy conservation is recommended.

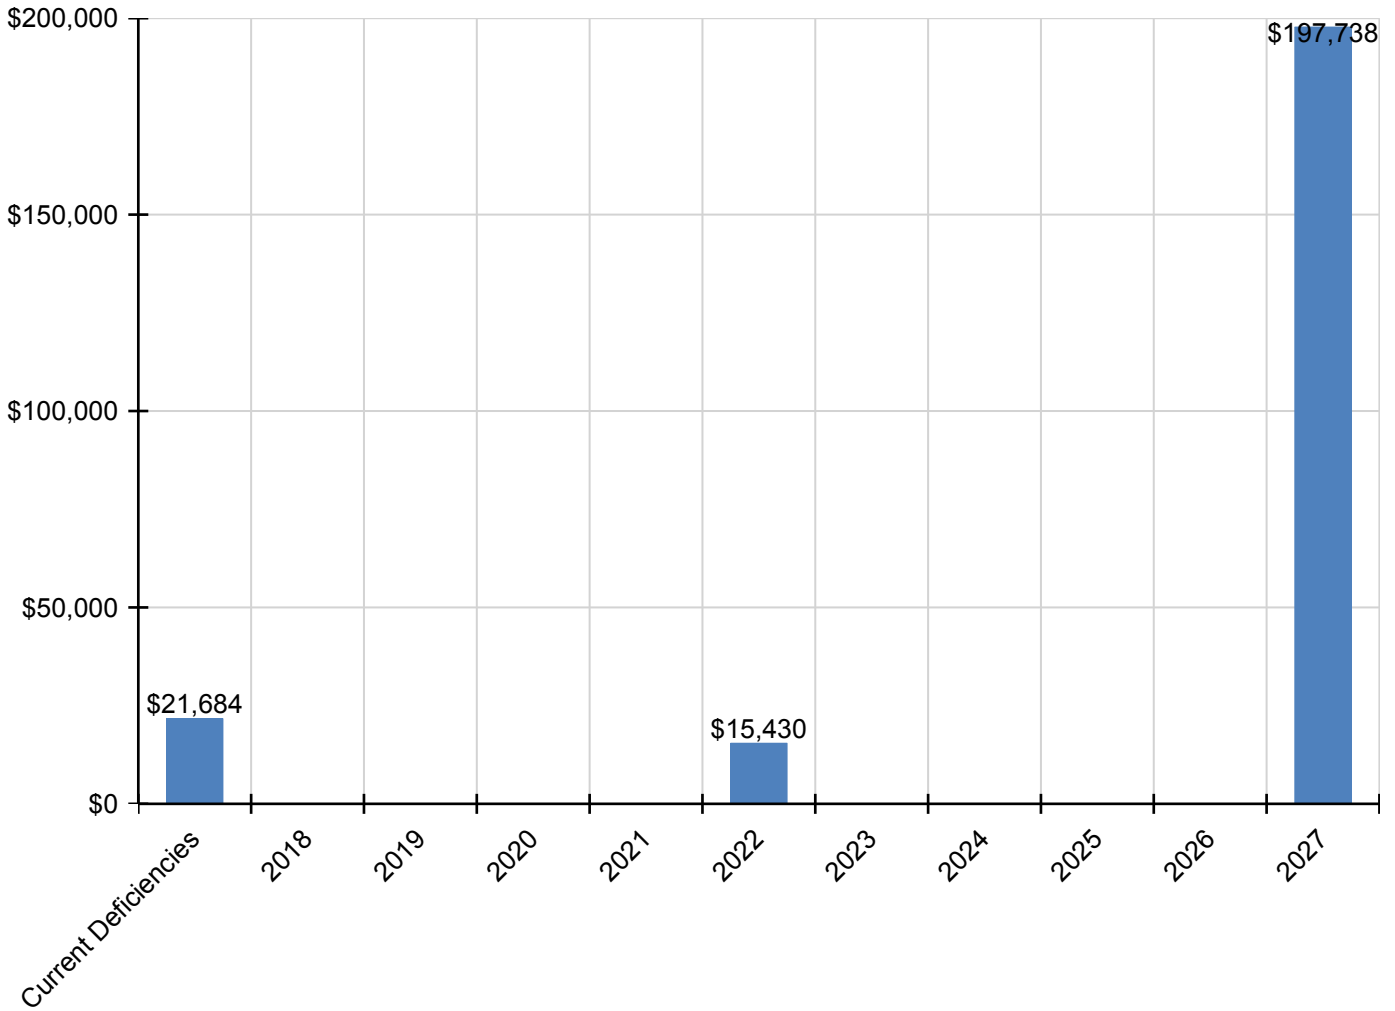
Forecasted Capital Renewal Requirement

The following chart shows the current building deficiencies and forecasting capital renewal or sustainment requirements over the next ten years.

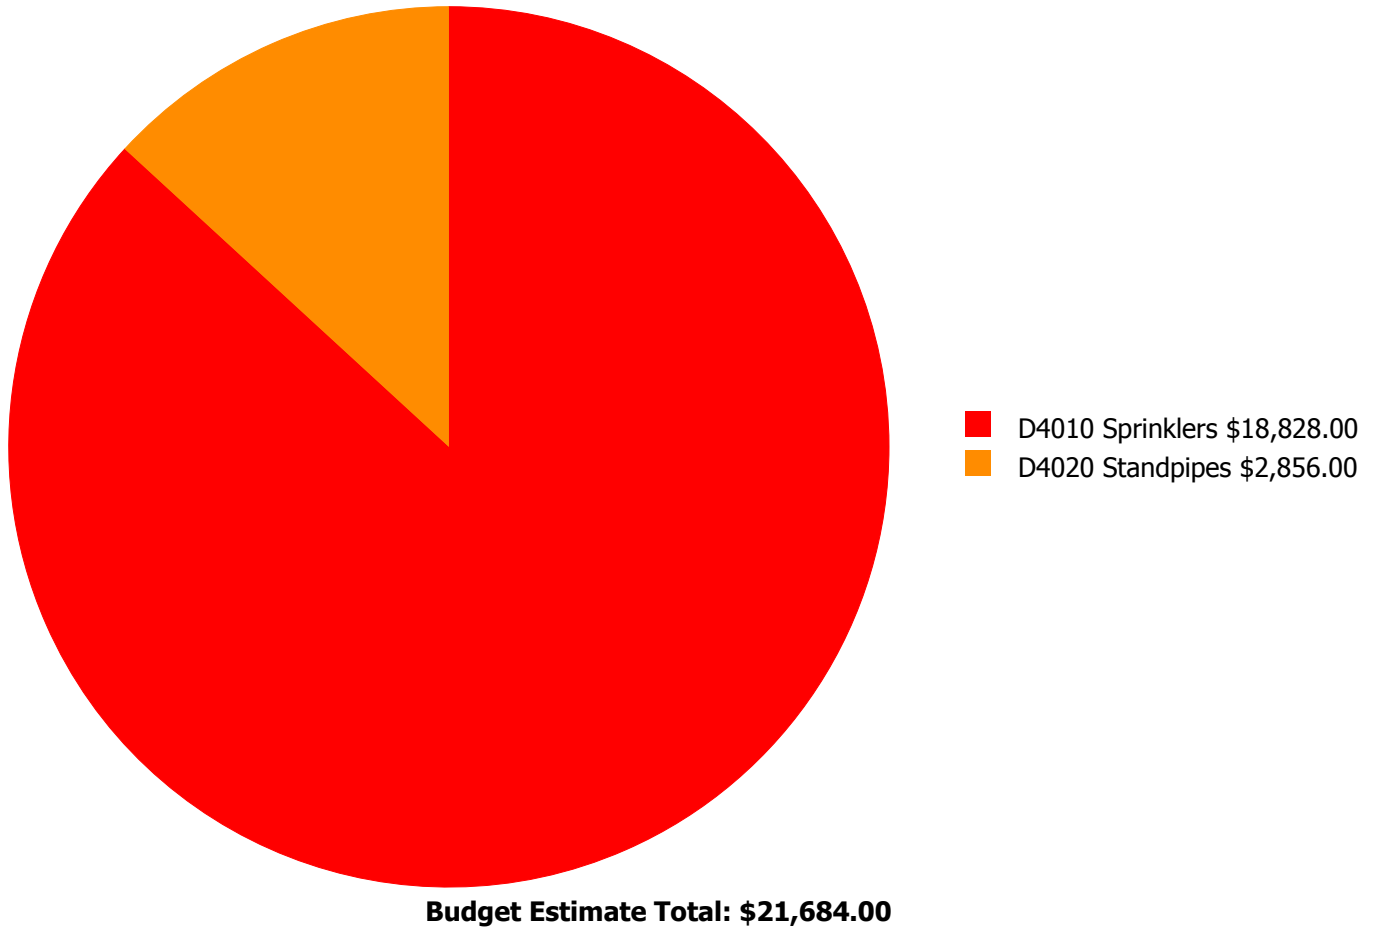
Deficiency Summary by System

Current deficiencies included assemblies that have reached or exceeded their design life or components of the assemblies that are in need of repair. Assemblies that have reached their design life are identified as current deficiencies and assigned the distress 'Beyond Useful Life'. The following chart lists all current deficiencies associated with this facility.

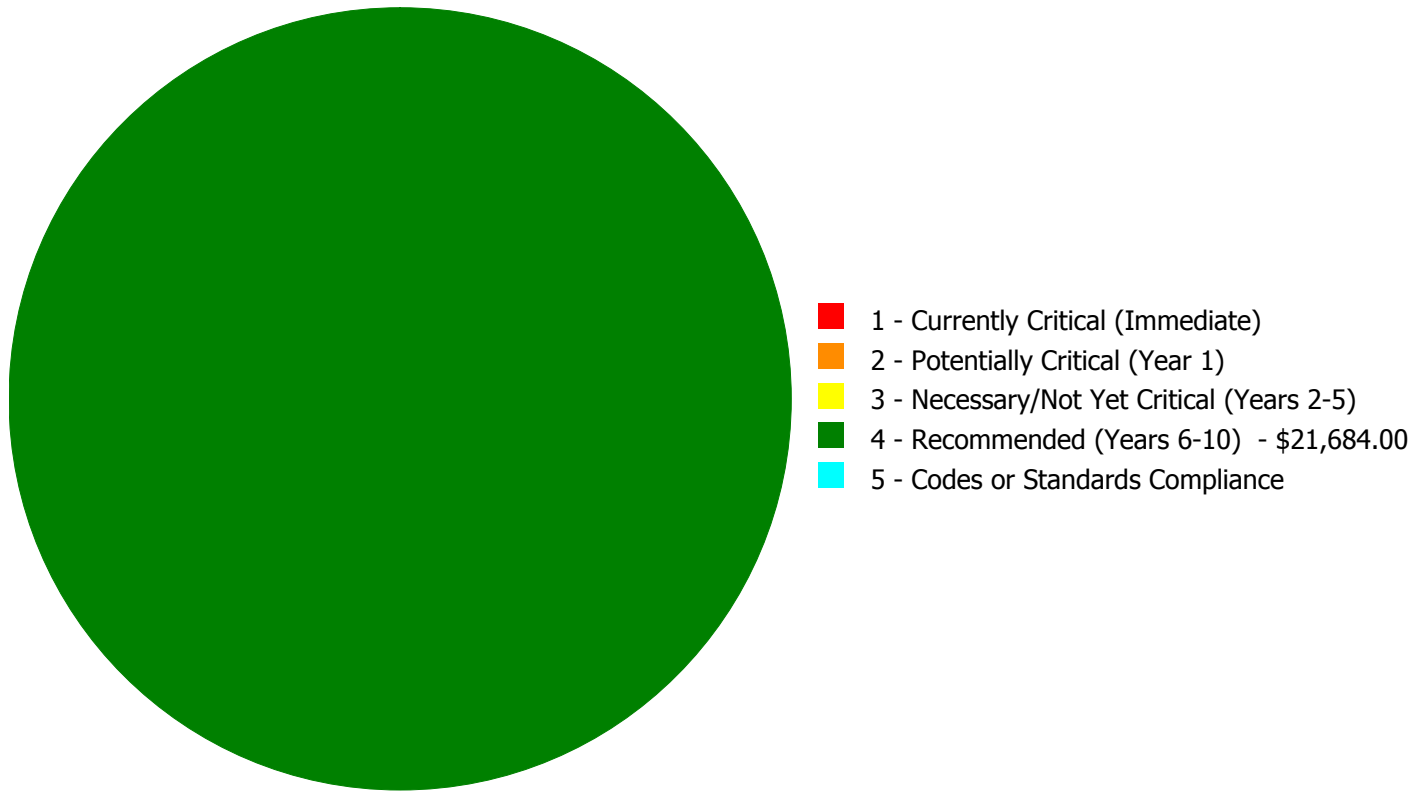
Deficiency Summary by Priority

The following chart shows the total repair costs broken down by priority. Assessors assigned deficiencies within eCOMET to one of the following priority categories:

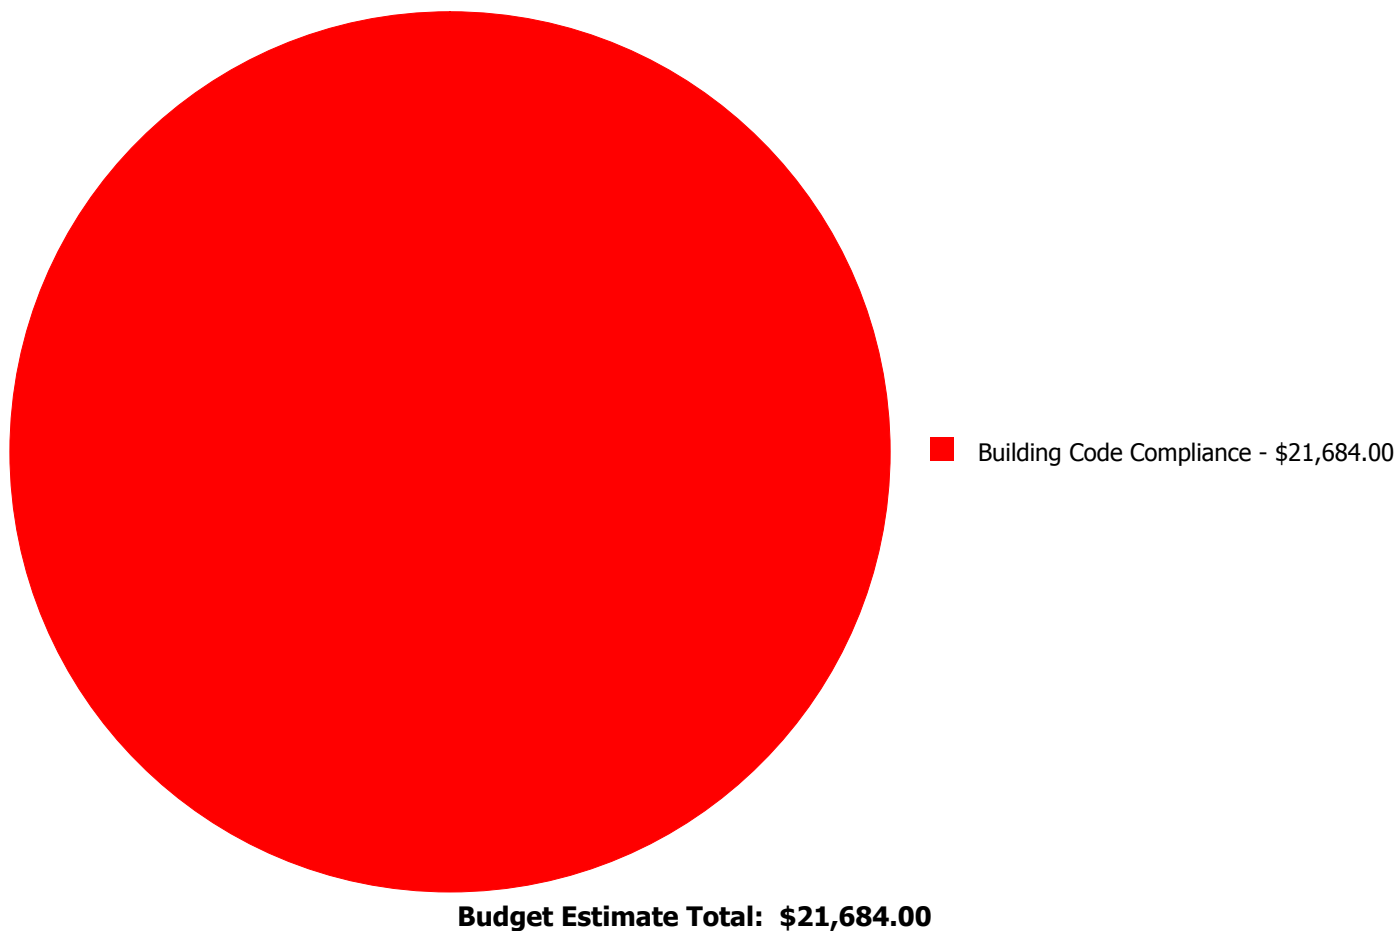
Deficiency Summary by Category

The following chart shows the total repair costs broken down by deficiency categories. Assessors assigned deficiencies to one of the following categories:

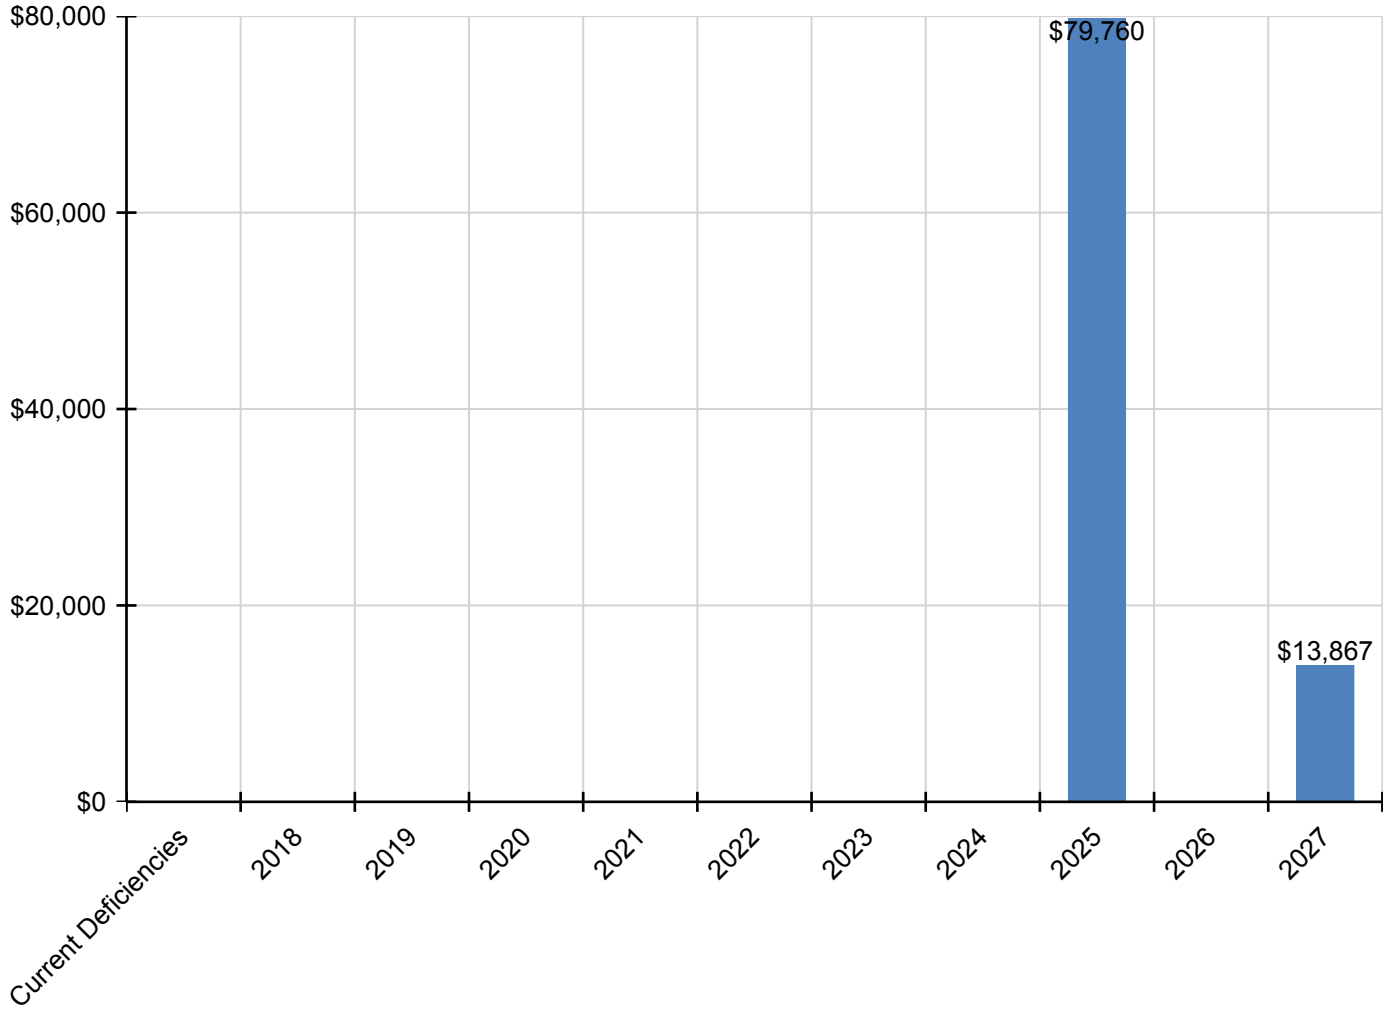
Forecasted Capital Renewal Requirement

The following chart shows the current building deficiencies and forecasting capital renewal or sustainment requirements over the next ten years.

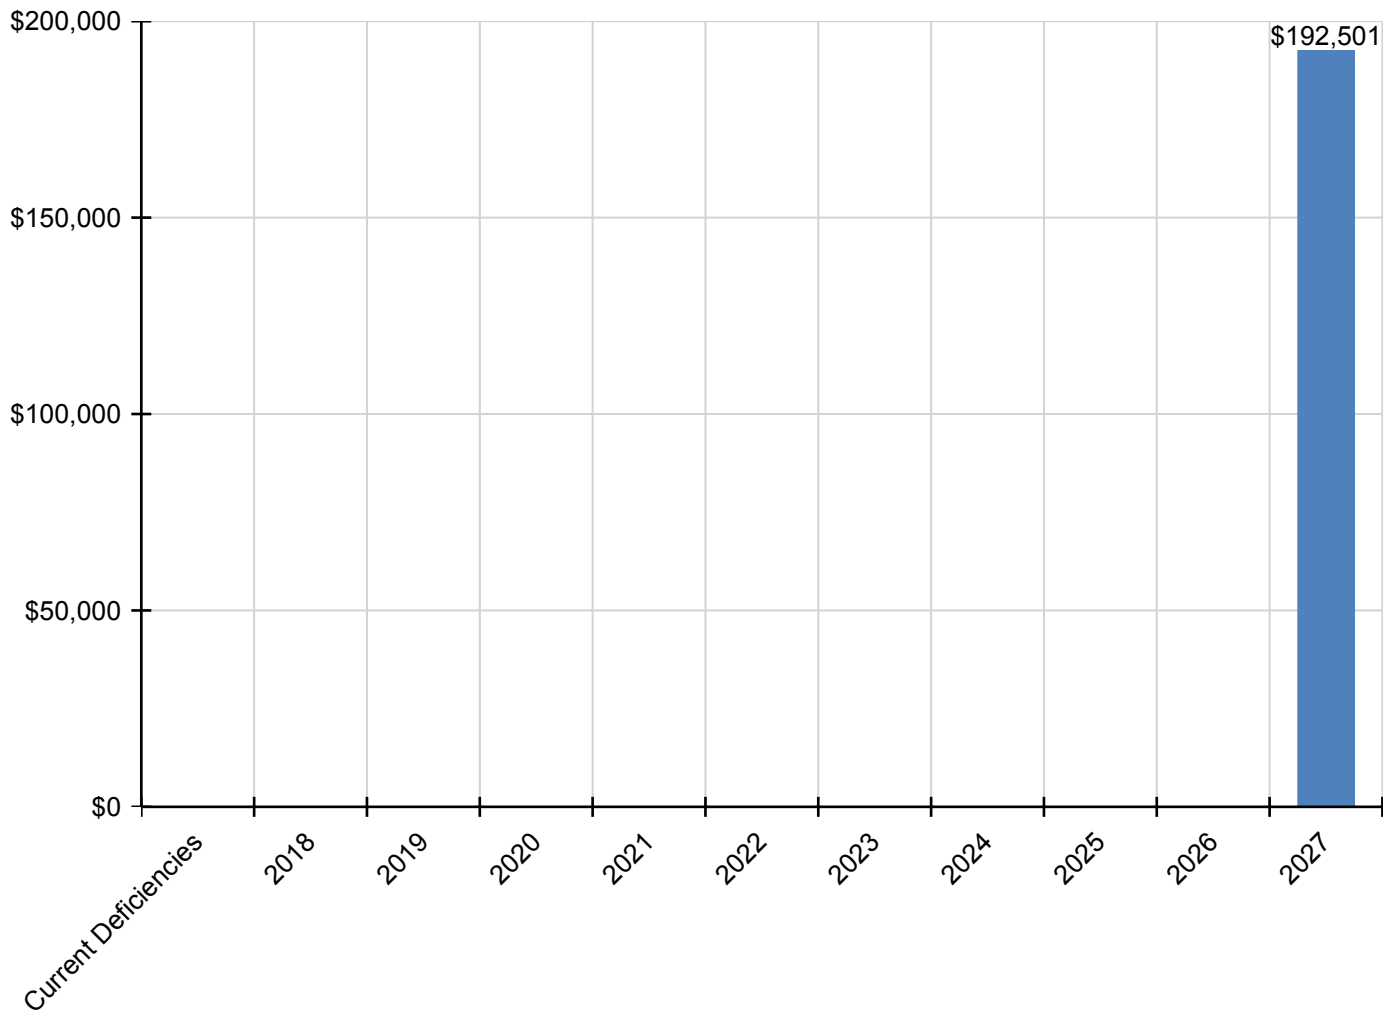
Forecasted Capital Renewal Requirement

The following chart shows the current building deficiencies and forecasting capital renewal or sustainment requirements over the next ten years.

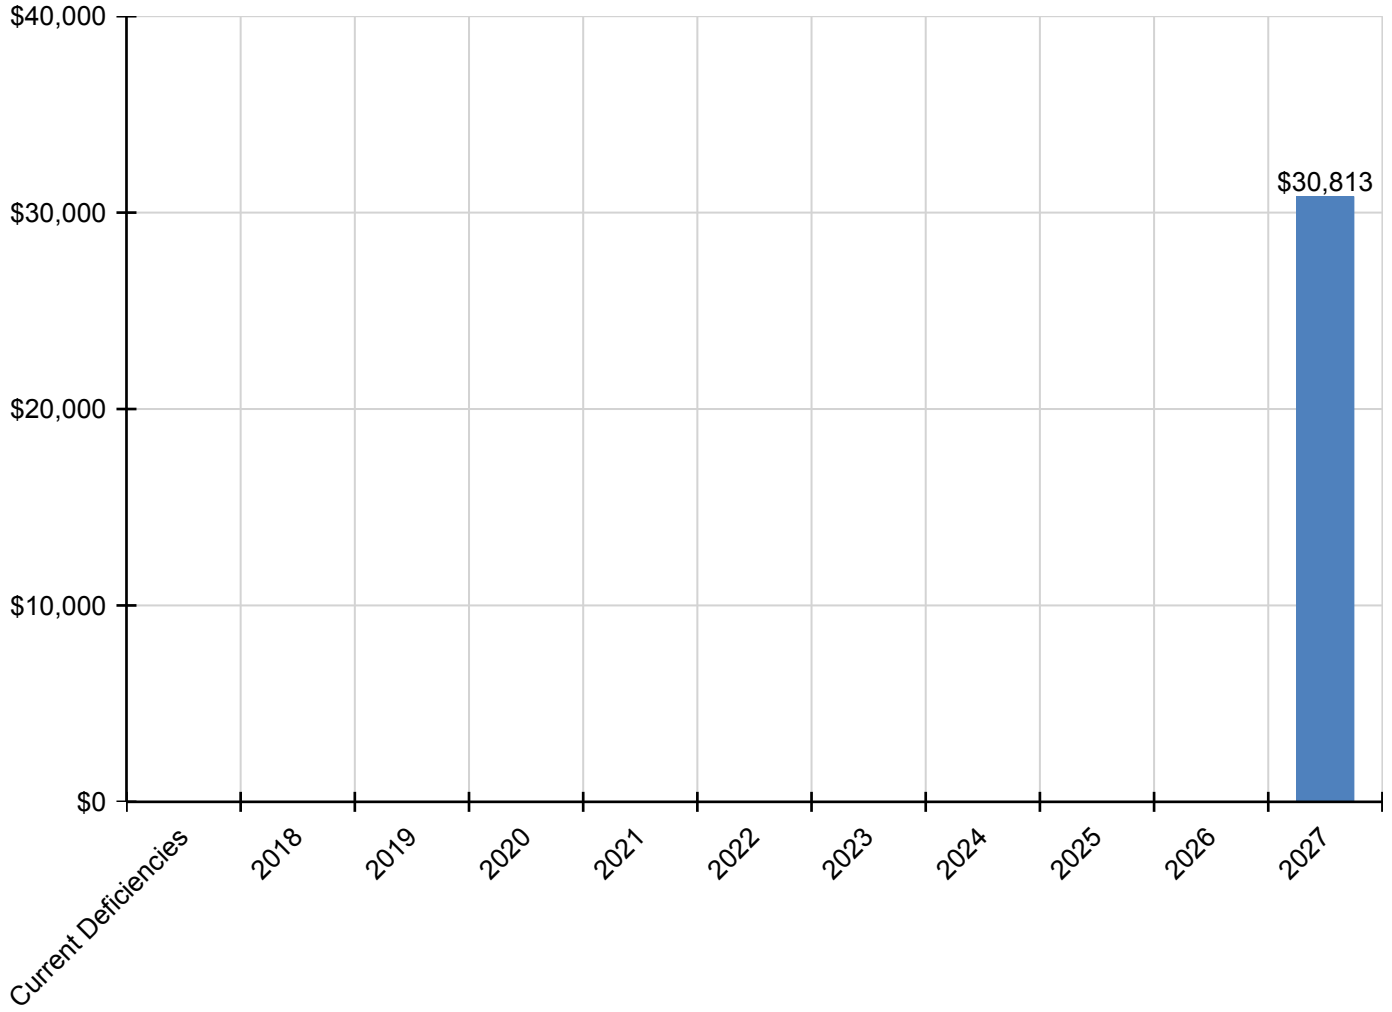
Forecasted Capital Renewal Requirement

The following chart shows the current building deficiencies and forecasting capital renewal or sustainment requirements over the next ten years.

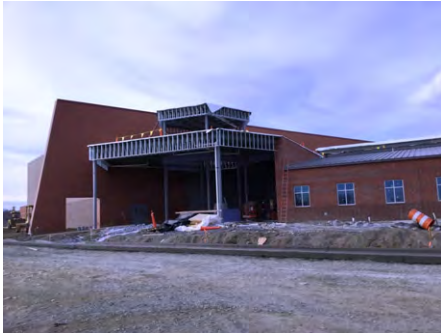
1). South Elevation - Jan 24, 2017

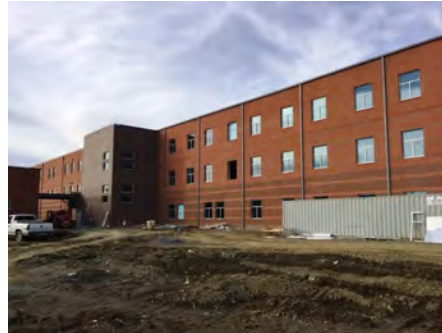
2). Southeast Elevation - Jan 24, 2017

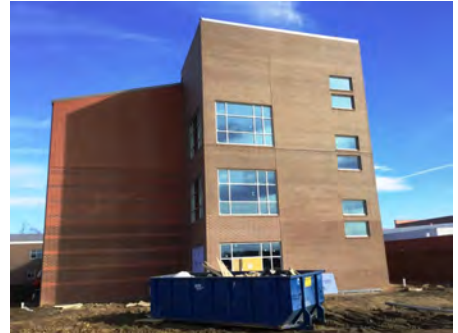
3). West Elevation - Jan 24, 2017

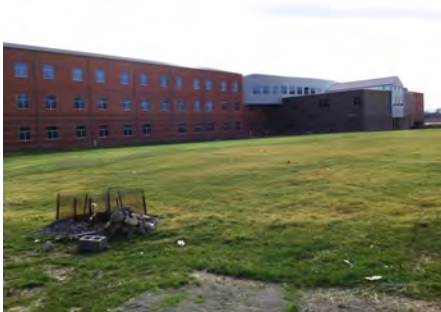
4). Northeast Elevation - Jan 24, 2017

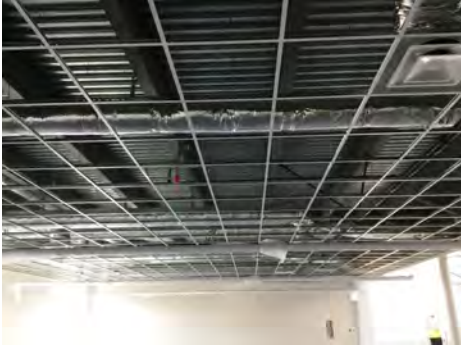
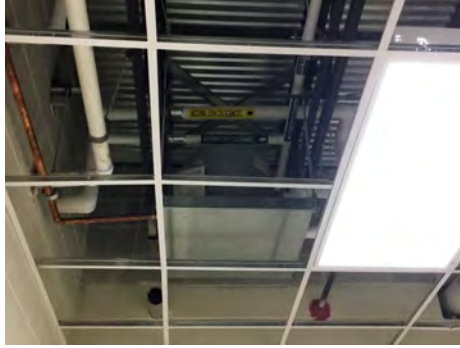
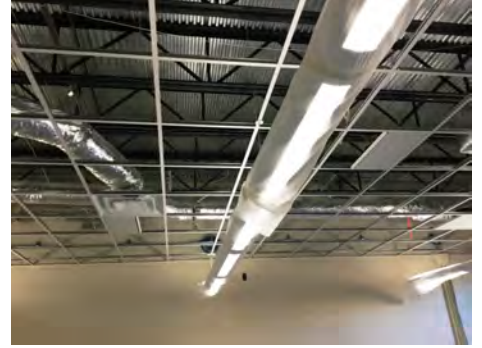
System: B1010 - Floor Construction

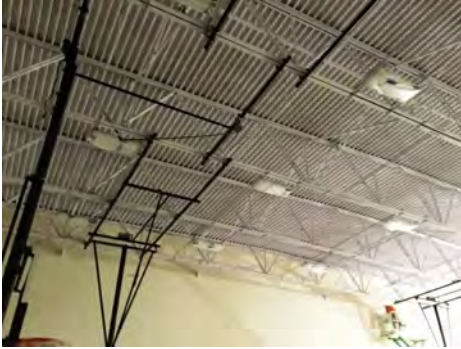
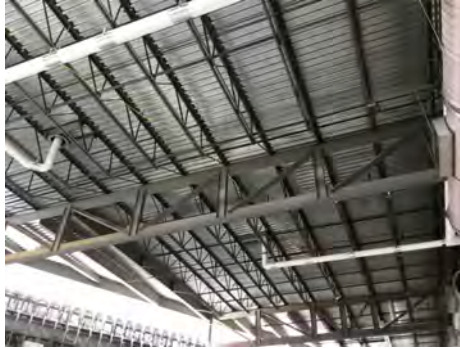
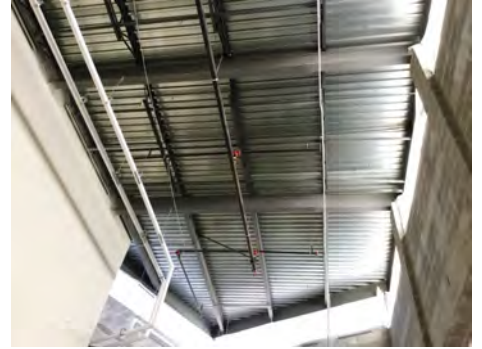
System: B1020 - Roof Construction

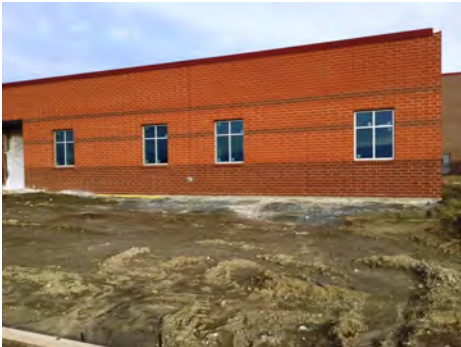
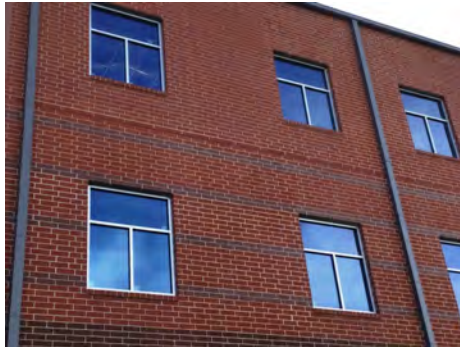
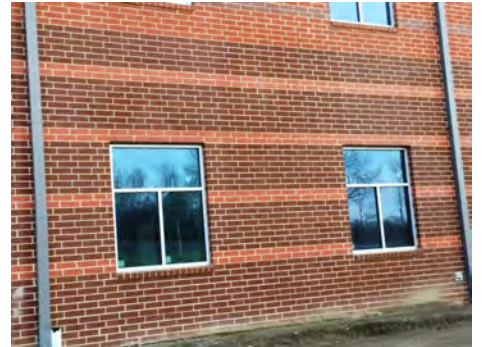
System: B2010 - Exterior Walls

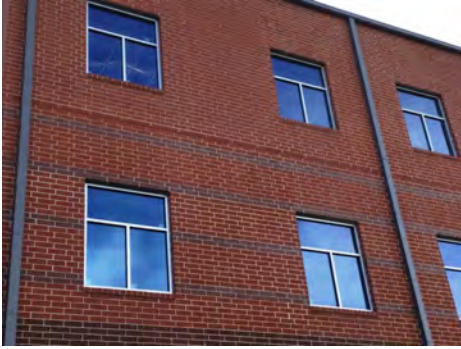
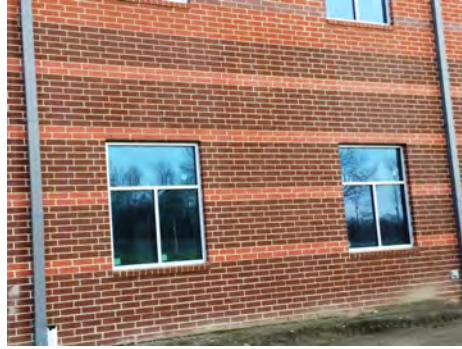
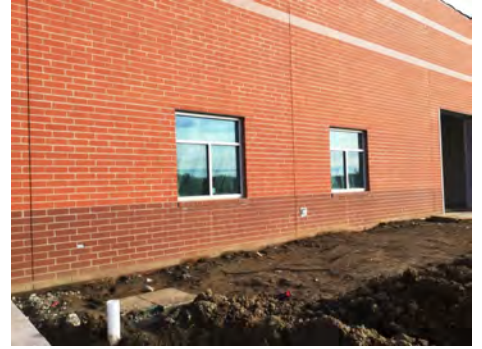
System: B2020 - Exterior Windows

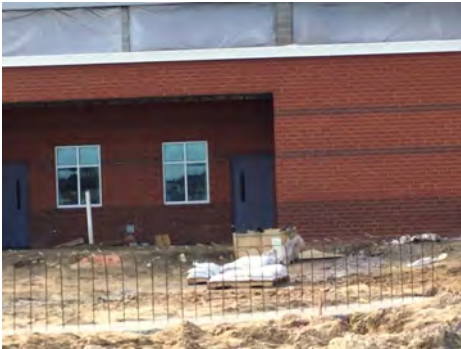
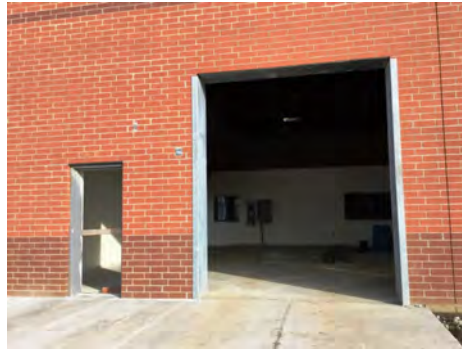
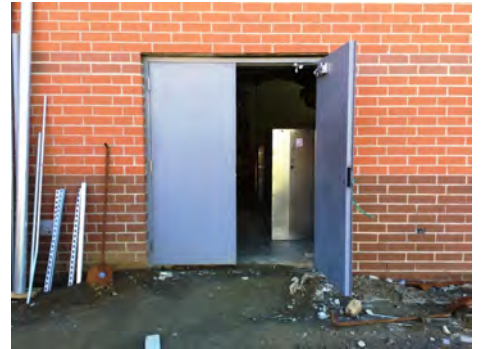
System: B2030 - Exterior Doors

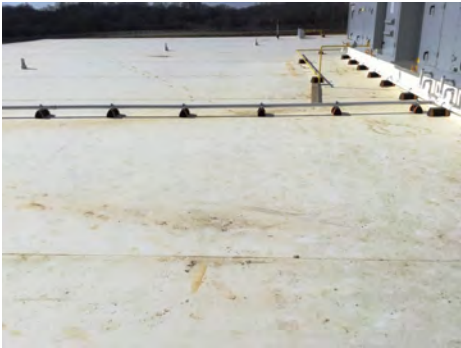
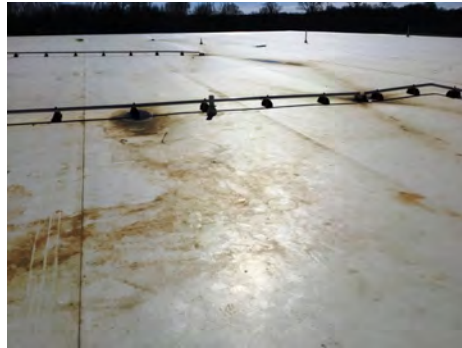
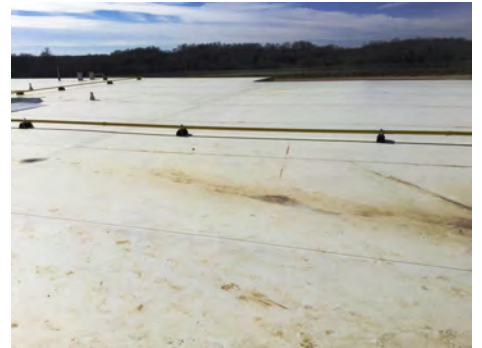
System: B3010120 - Single Ply Membrane

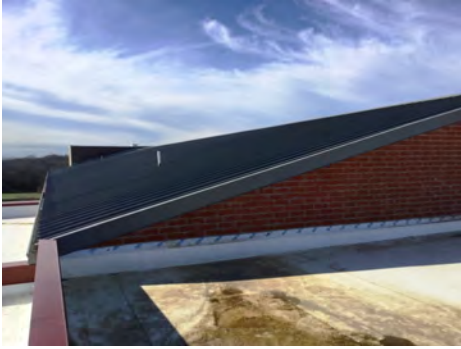
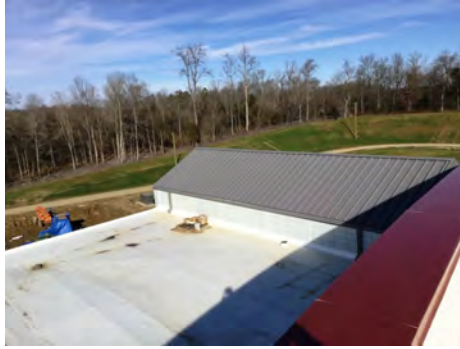
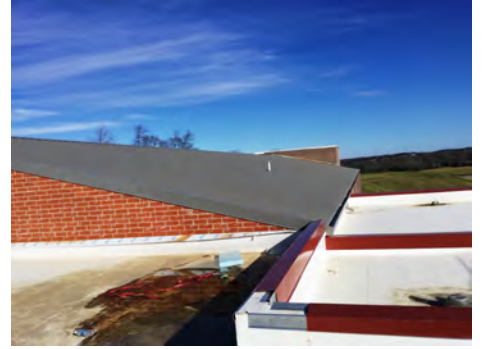
System: B3010130 - Preformed Metal Roofing

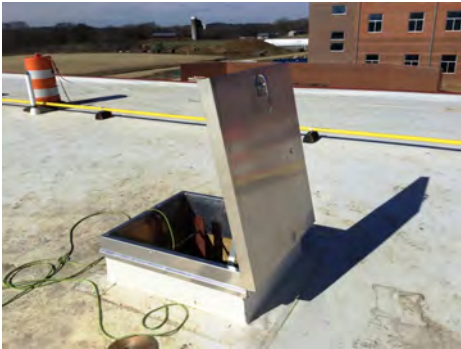
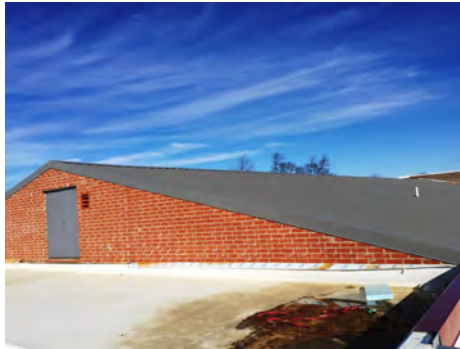
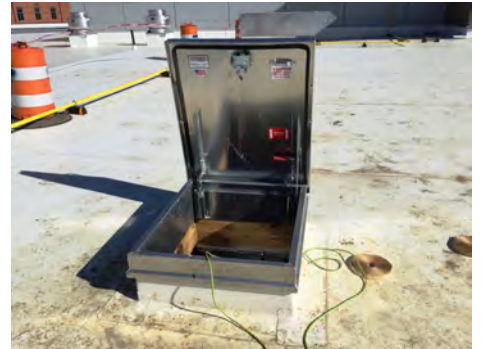
System: B3020 - Roof Openings

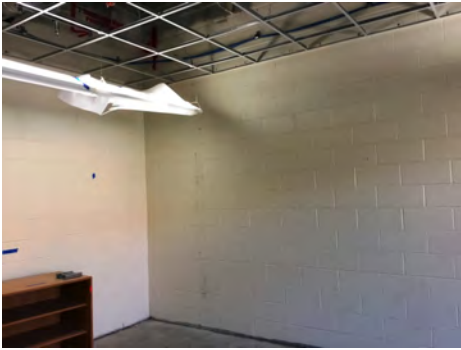
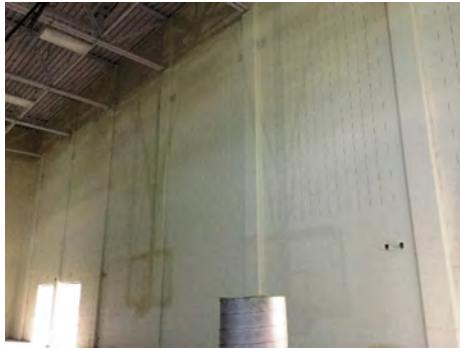
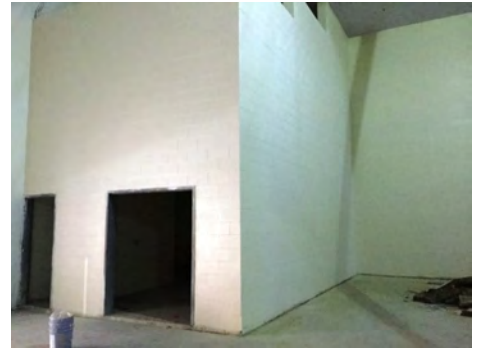
System: C1010 - Partitions

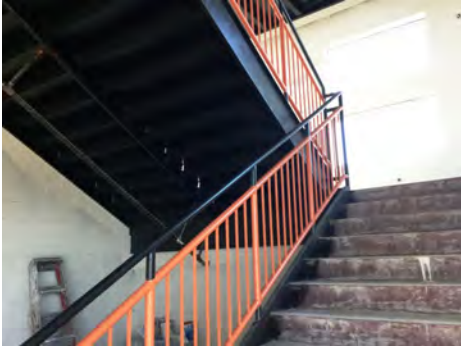
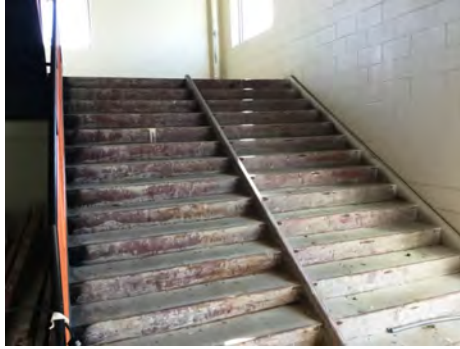
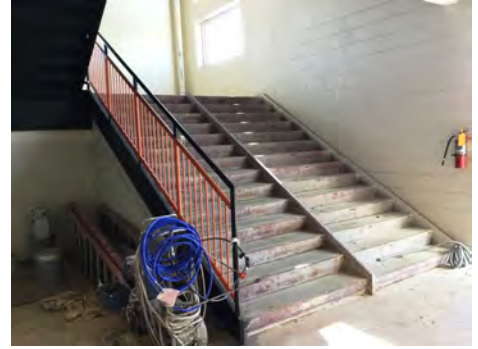
System: C2010 - Stair Construction

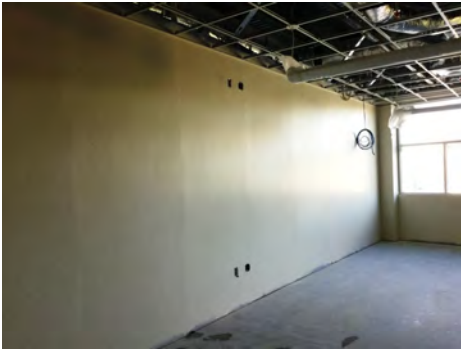
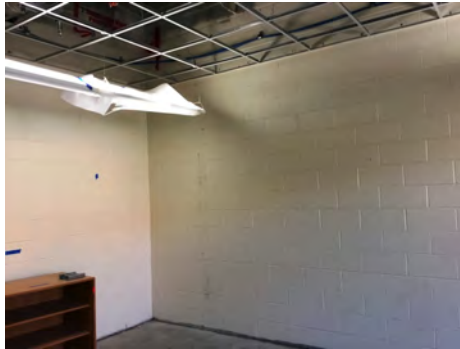
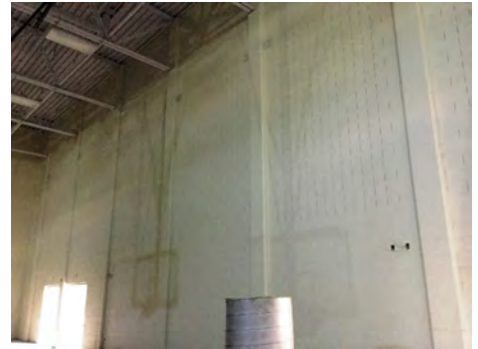
System: C3010 - Wall Finishes

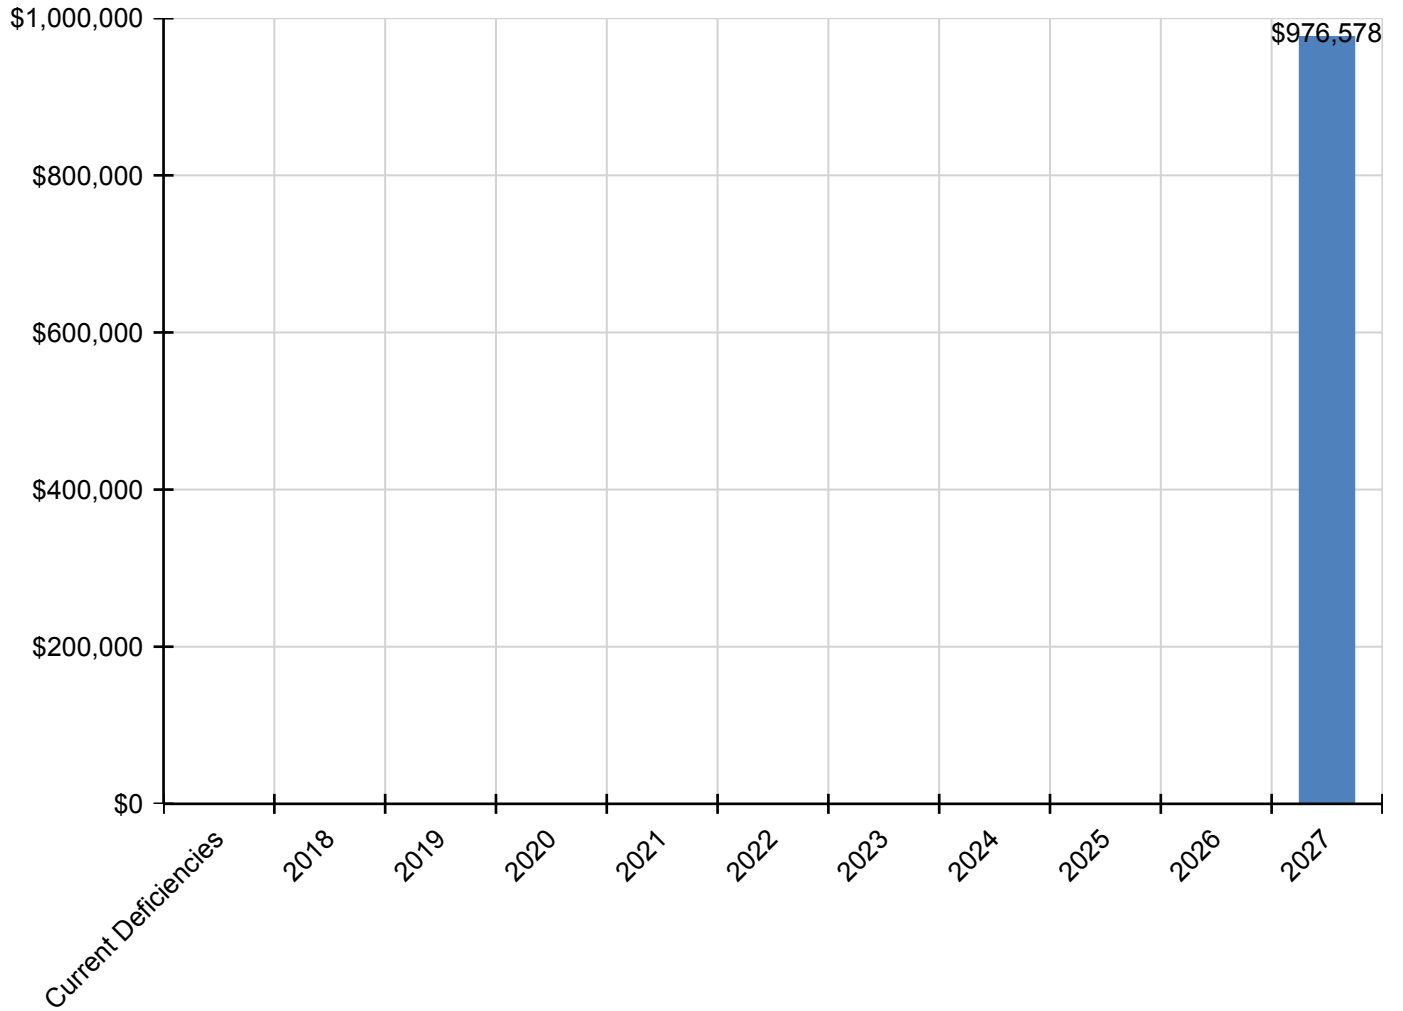
Forecasted Capital Renewal Requirement

The following chart shows the current building deficiencies and forecasting capital renewal or sustainment requirements over the next ten years.

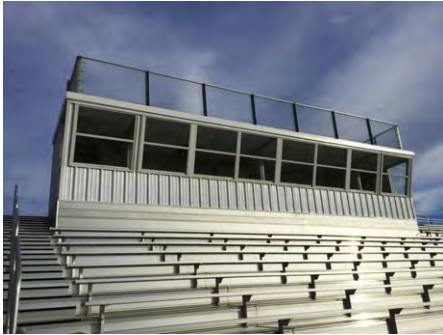
1). West Elevation - Jan 24, 2017

The photo album consists of the various cardinal directions of the building..

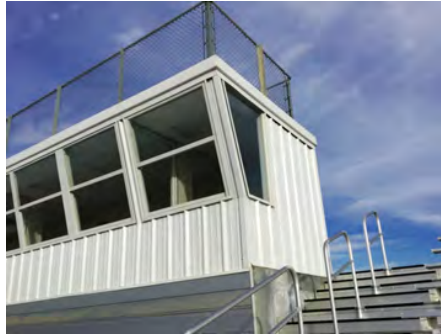
2). Southwest Elevation - Jan 24, 2017

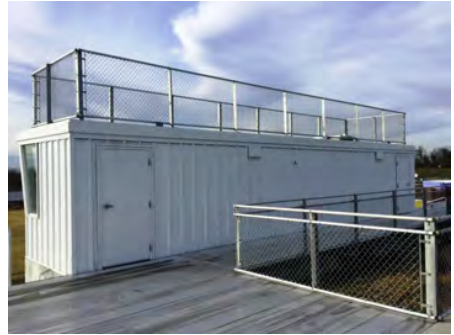
3). East Elevation - Jan 24, 2017

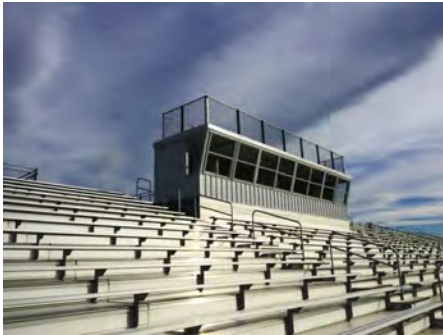
4). North Elevation - Jan 24, 2017

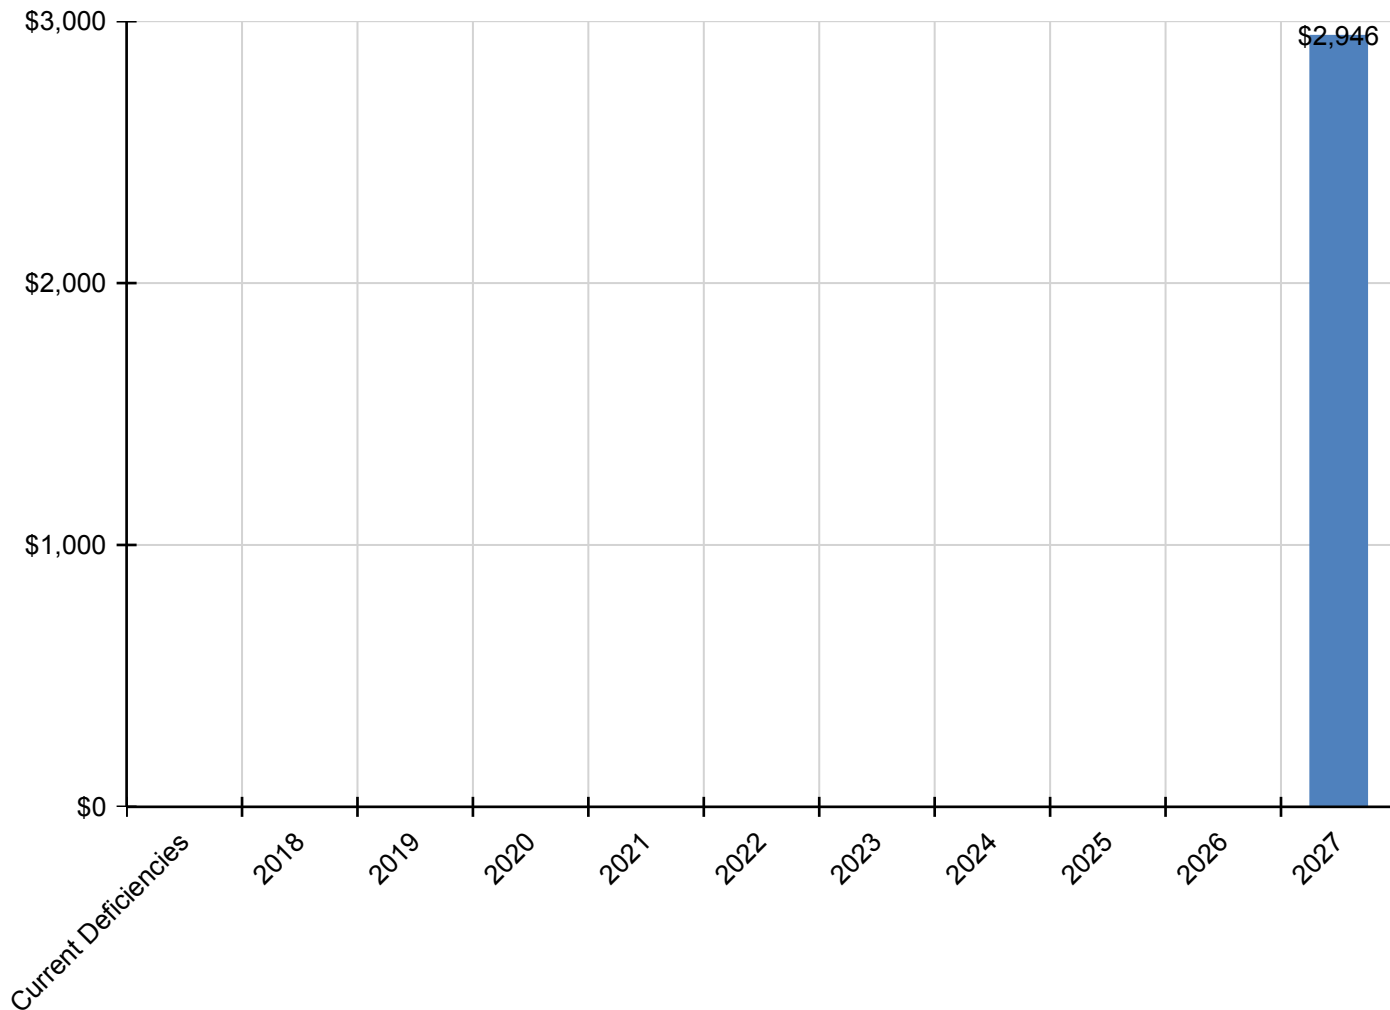
Forecasted Capital Renewal Requirement

The following chart shows the current building deficiencies and forecasting capital renewal or sustainment requirements over the next ten years.

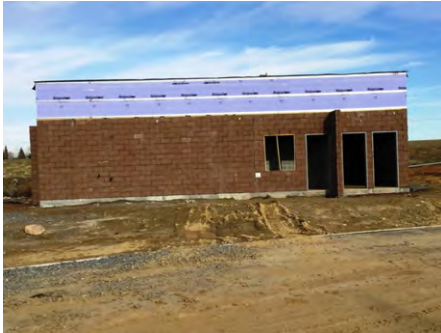
1). West Elevation - Jan 24, 2017

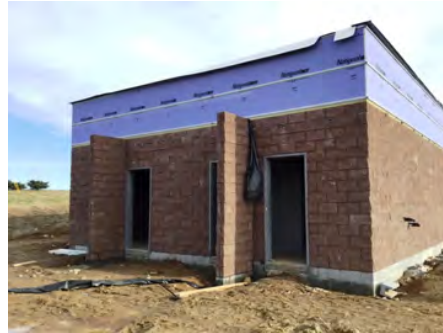
2). North Elevation - Jan 24, 2017

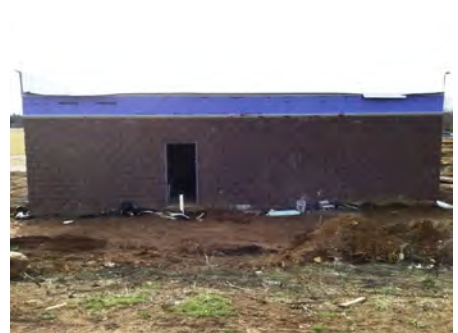
3). East Elevation - Jan 24, 2017

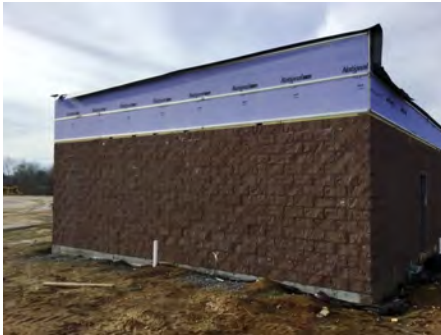
4). South Elevation - Jan 24, 2017
