NC School District/300 Davie County/High School

Central Davie Academy

Campus Assessment Report

March 7, 2017

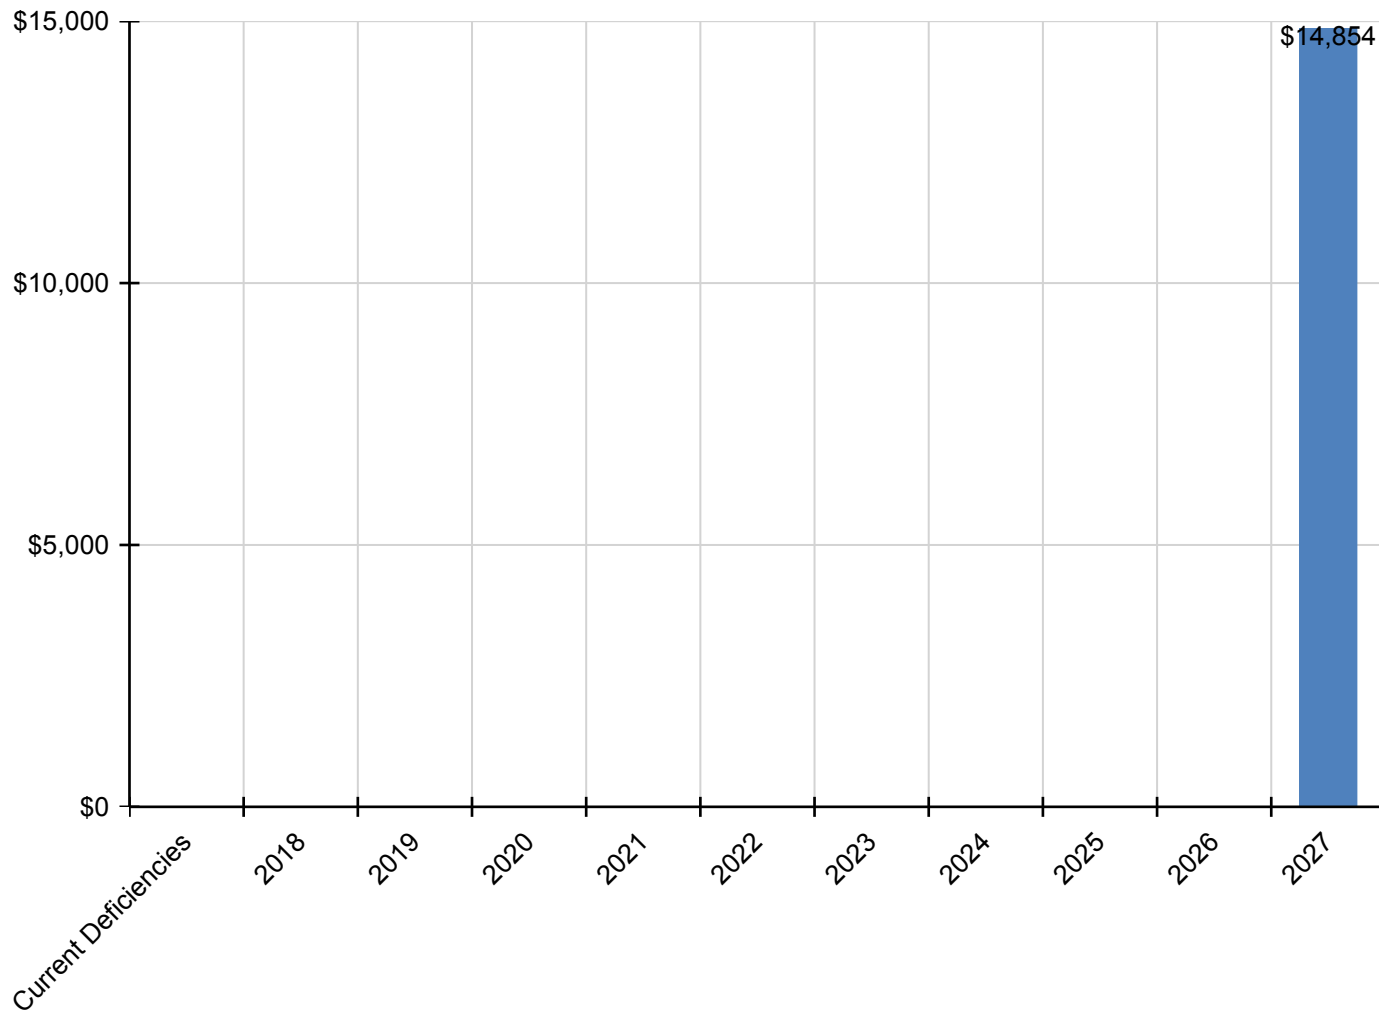
Forecasted Capital Renewal Requirement

The following chart shows the current building deficiencies and forecasting capital renewal or sustainment requirements over the next ten years.

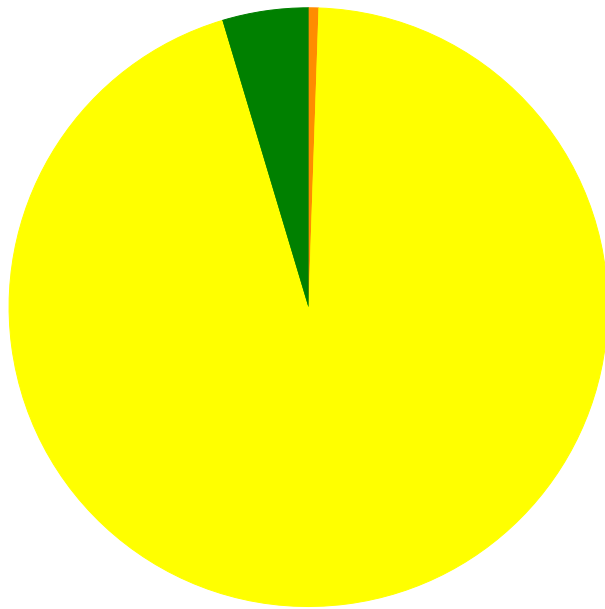
Deficiencies By Priority

- 1 - Currently Critical (Immediate)
- 2 - Potentially Critical (Year 1) - \$47,297.00
- 3 - Necessary/Not Yet Critical (Years 2-5) - \$8,338,159.00
- 4 - Recommended (Years 6-10) - \$407,570.00
- 5 - Codes or Standards Compliance

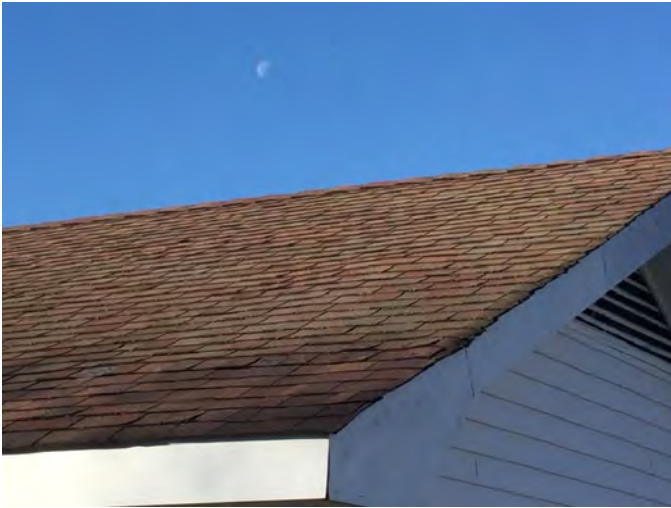
System: B3010140 - Asphalt Shingles

Location: Roof
Distress: Beyond Service Life
Category: Deferred Maintenance
Priority: 3 - Necessary/Not Yet Critical (Years 2-5)
Correction: Renew System
Qty: 1,070.00
Unit of Measure: S.F.
Estimate: \$6,749.00
Assessor Name: Eduardo Lopez
Date Created: 01/19/2017

Notes: The asphalt shingles roof covering is aged, showing signs of failure and should be replaced.

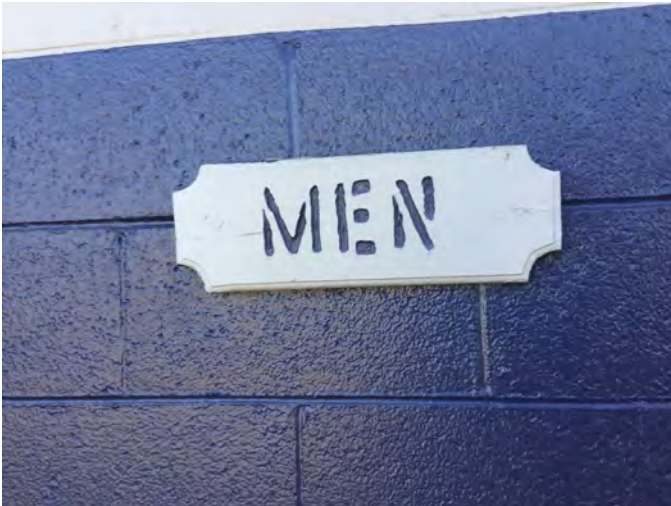
System: C1030 - Fittings

Location: Throughout the Building
Distress: Beyond Service Life
Category: Deferred Maintenance / Accessibility Code Compliance
Priority: 3 - Necessary/Not Yet Critical (Years 2-5)
Correction: Renew System
Qty: 1,070.00
Unit of Measure: S.F.
Estimate: \$9,969.00
Assessor Name: Eduardo Lopez
Date Created: 01/19/2017

Notes: The fittings throughout the building are aged, in marginal condition, partitions and signage are not ADA compliant and should be replaced.

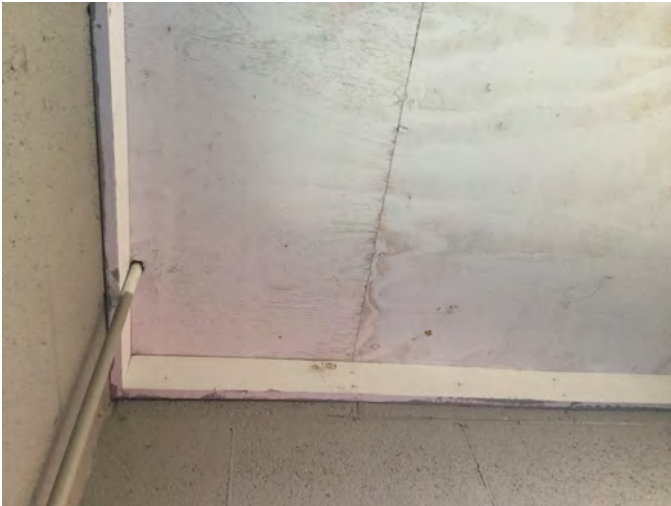
System: C3030 - Ceiling Finishes

Location: Throughout the Building
Distress: Beyond Service Life
Category: Deferred Maintenance
Priority: 3 - Necessary/Not Yet Critical (Years 2-5)
Correction: Renew System
Qty: 1,070.00
Unit of Measure: S.F.
Estimate: \$11,217.00
Assessor Name: Eduardo Lopez
Date Created: 01/19/2017

Notes: The original ceiling finishes are aged, failing and should be replaced.

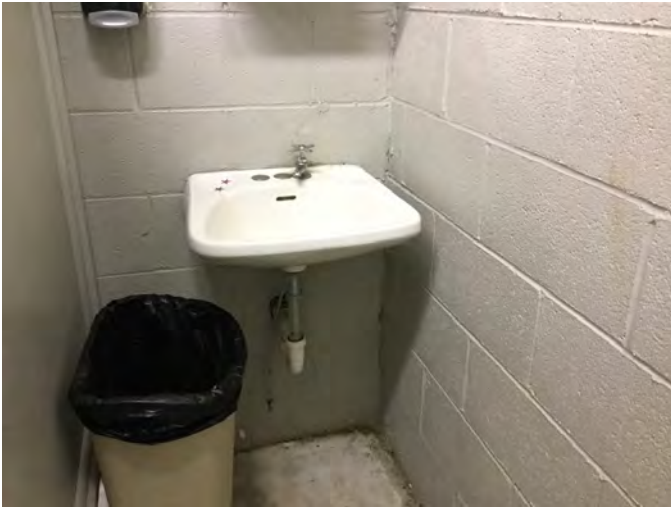
System: D2010 - Plumbing Fixtures

Location: Throughout the Building
Distress: Beyond Service Life
Category: Deferred Maintenance
Priority: 3 - Necessary/Not Yet Critical (Years 2-5)
Correction: Renew System
Qty: 1,070.00
Unit of Measure: S.F.
Estimate: \$11,746.00
Assessor Name: Eduardo Lopez
Date Created: 01/19/2017

Notes: Plumbing fixtures are in operational conditions. However, they are aged, not ADA compliant, and should be scheduled for replacement.

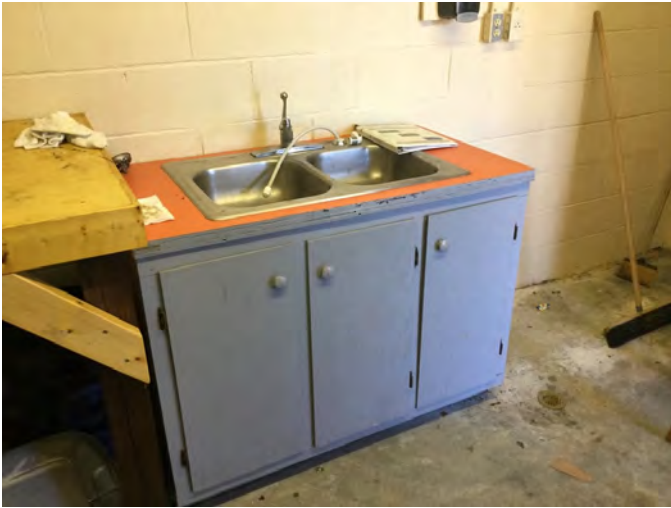
System: E2010 - Fixed Furnishings

Location: Throughout the Building
Distress: Beyond Service Life
Category: Deferred Maintenance
Priority: 3 - Necessary/Not Yet Critical (Years 2-5)
Correction: Renew System
Qty: 1,070.00
Unit of Measure: S.F.
Estimate: \$5,979.00
Assessor Name: Eduardo Lopez
Date Created: 01/19/2017

Notes: The fixed furnishings are aged, in marginal condition, and should be replaced.

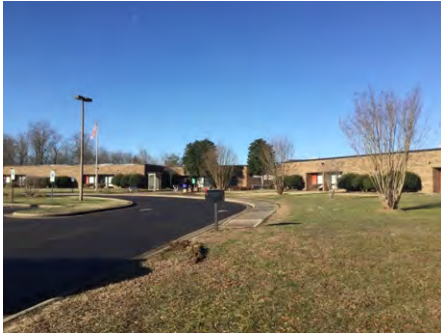
1). East Elevation - Feb 10, 2017

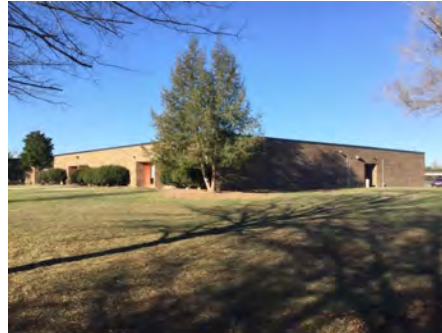
2). North Elevation - Feb 10, 2017

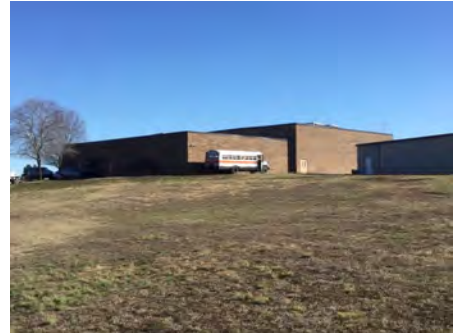
3). West Elevation - Feb 10, 2017

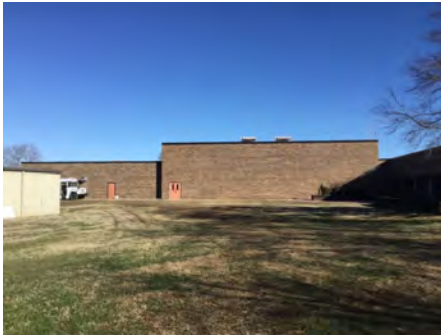
4). Southwest Elevation - Feb 10, 2017

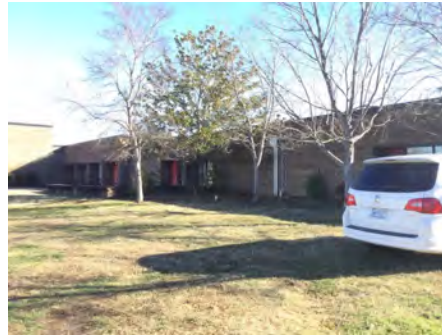
5). Southwest Elevation - Feb 10, 2017

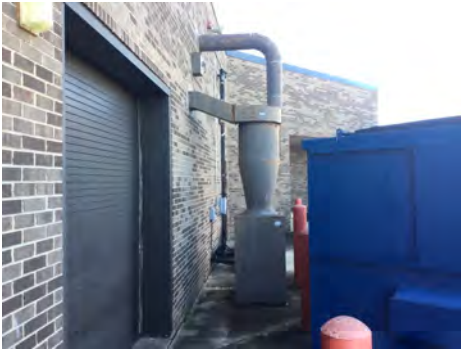
System: D3090 - Other HVAC Systems/Equip

Note: No longer in use.

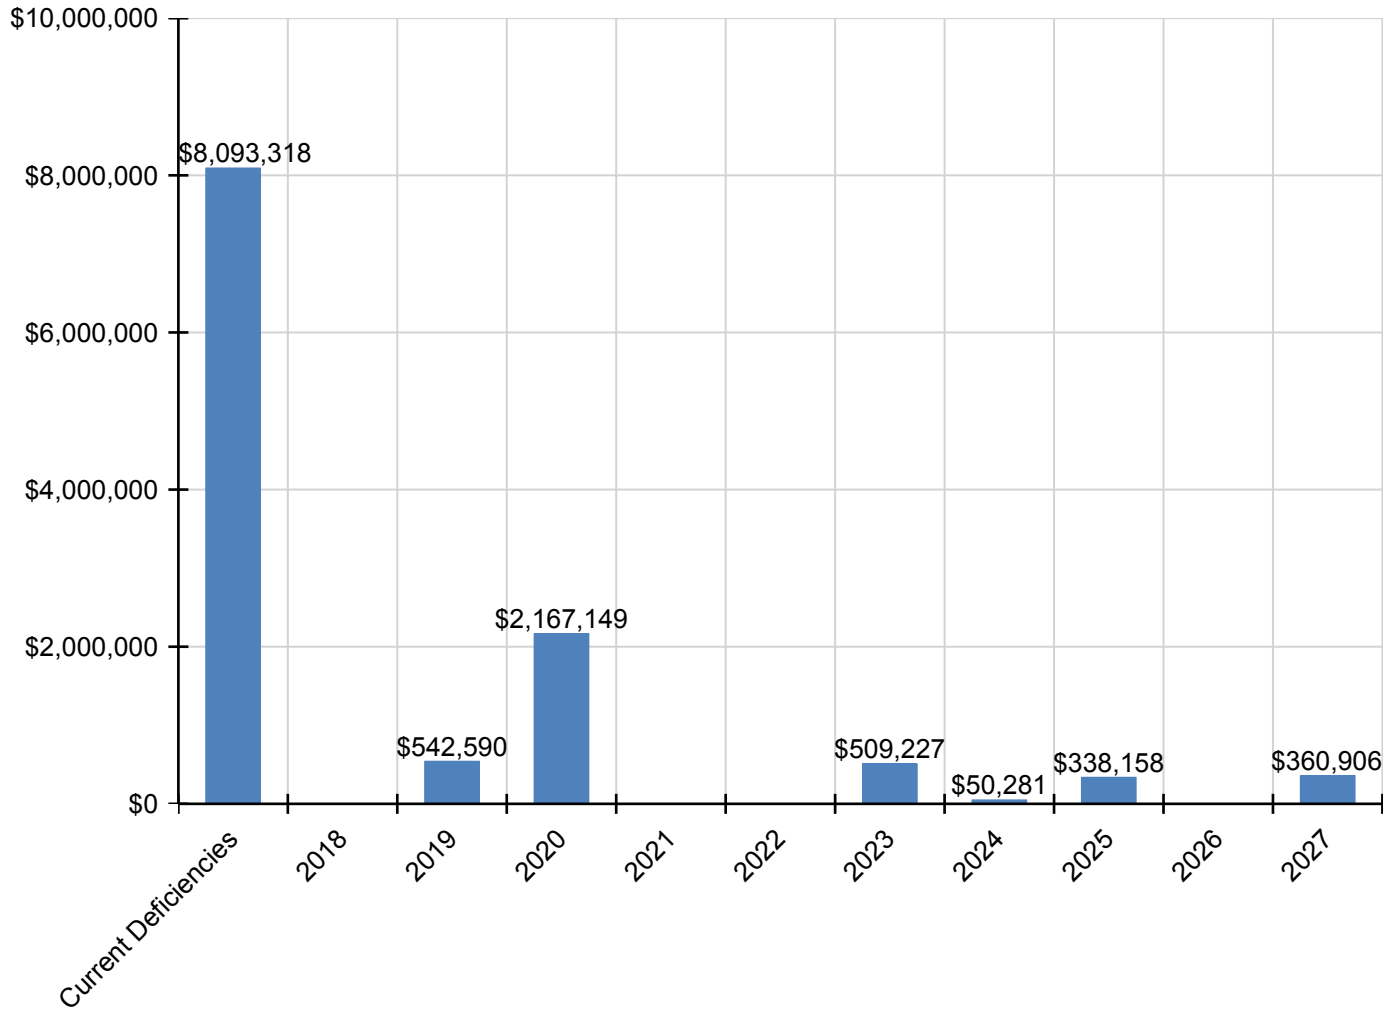
Forecasted Capital Renewal Requirement

The following chart shows the current building deficiencies and forecasting capital renewal or sustainment requirements over the next ten years.

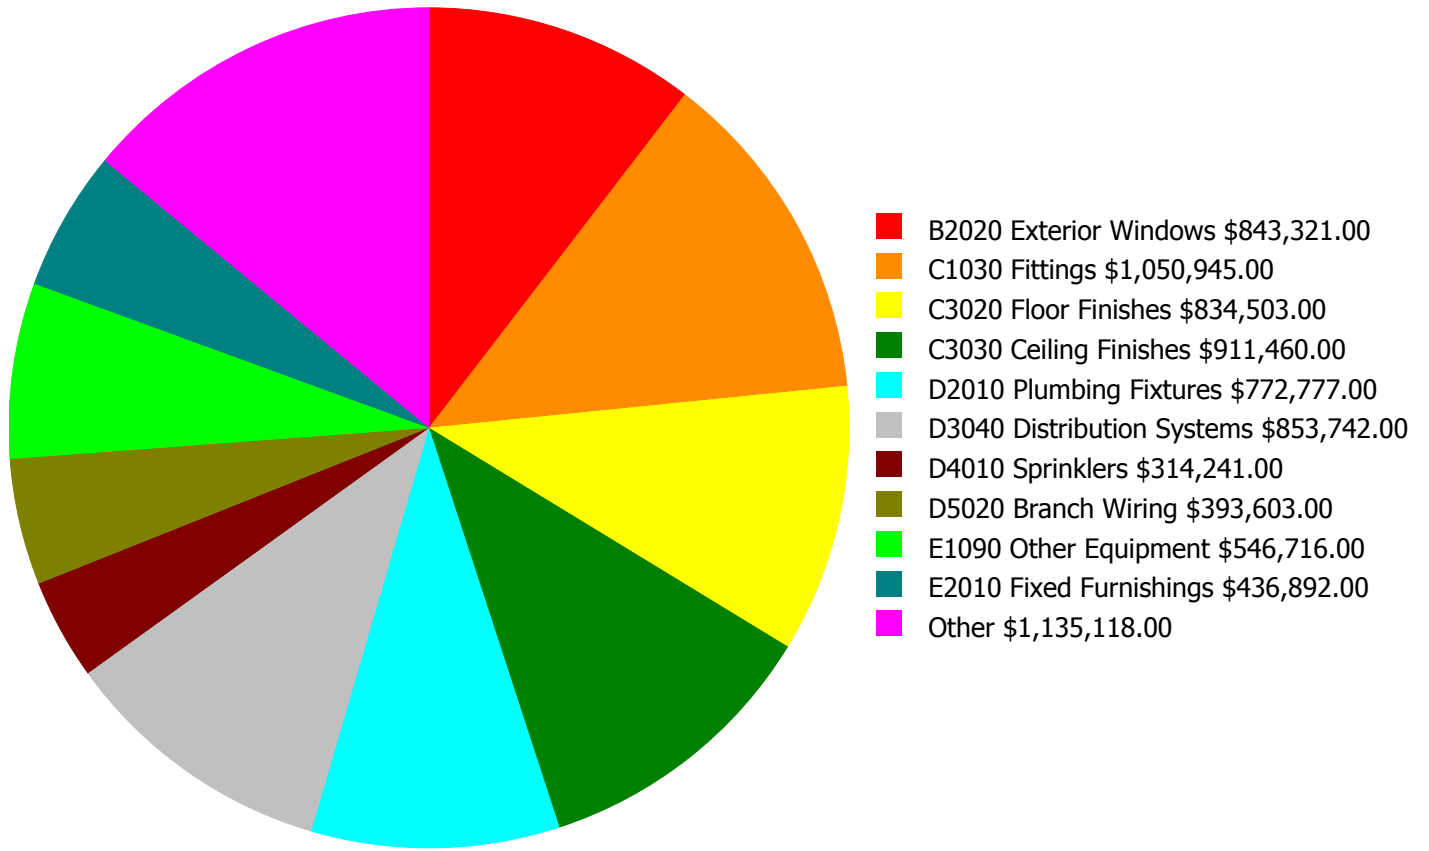
Deficiency Summary by System

Current deficiencies included assemblies that have reached or exceeded their design life or components of the assemblies that are in need of repair. Assemblies that have reached their design life are identified as current deficiencies and assigned the distress 'Beyond Useful Life'. The following chart lists all current deficiencies associated with this facility.

Budget Estimate Total: \$8,093,318.00

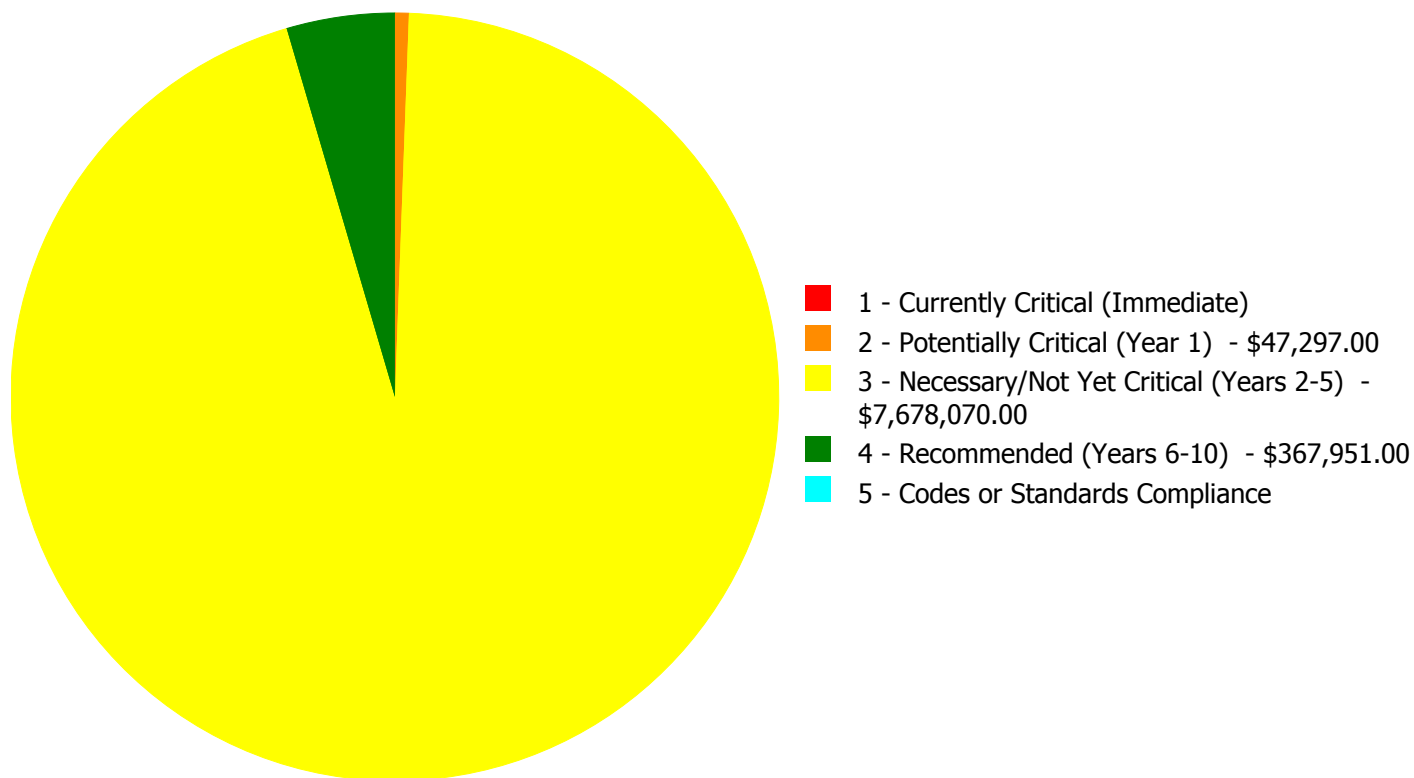
Deficiency Summary by Priority

The following chart shows the total repair costs broken down by priority. Assessors assigned deficiencies within eCOMET to one of the following priority categories:

Budget Estimate Total: \$8,093,318.00

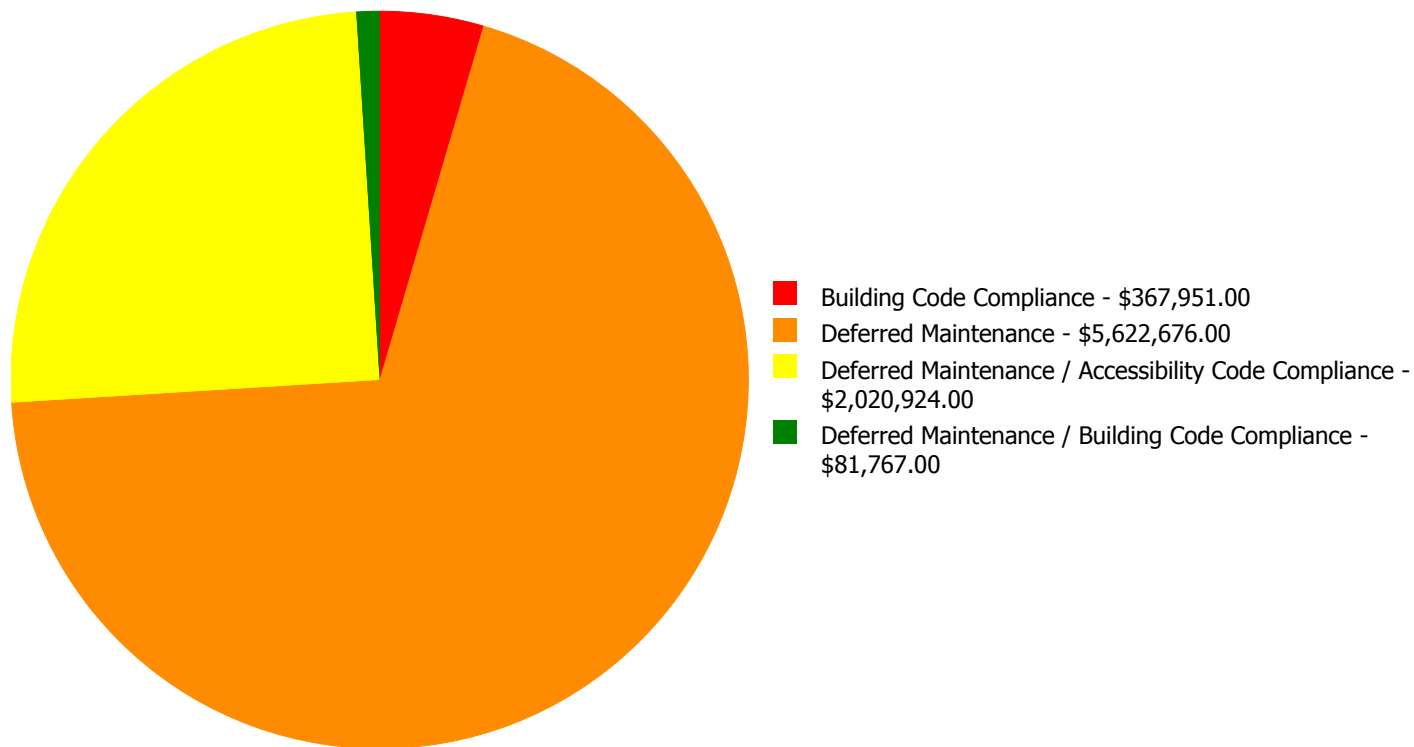
Deficiency Summary by Category

The following chart shows the total repair costs broken down by deficiency categories. Assessors assigned deficiencies to one of the following categories:

Budget Estimate Total: \$8,093,318.00

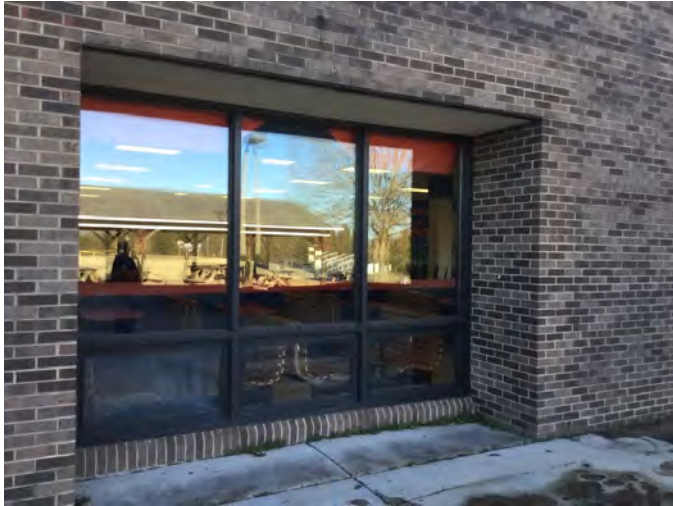
System: B2020 - Exterior Windows

Location: Exterior Walls
Distress: Beyond Service Life
Category: Deferred Maintenance
Priority: 3 - Necessary/Not Yet Critical (Years 2-5)
Correction: Renew System
Qty: 72,876.00
Unit of Measure: S.F.
Estimate: \$843,321.00
Assessor Name: Eduardo Lopez
Date Created: 01/19/2017

Notes: The exterior windows are aged, not energy efficient and should be replaced.

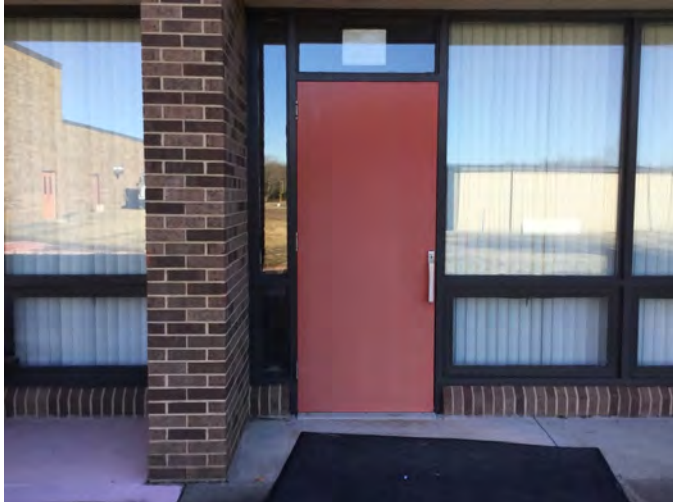
System: B2030 - Exterior Doors

Location: Exterior Walls
Distress: Beyond Service Life
Category: Deferred Maintenance / Building Code Compliance
Priority: 3 - Necessary/Not Yet Critical (Years 2-5)
Correction: Renew System
Qty: 72,876.00
Unit of Measure: S.F.
Estimate: \$81,767.00
Assessor Name: Eduardo Lopez
Date Created: 01/19/2017

Notes: The exterior doors are aged, rusted and should be replaced. Including the electrical room exit door doesn't comply with current Building Codes.

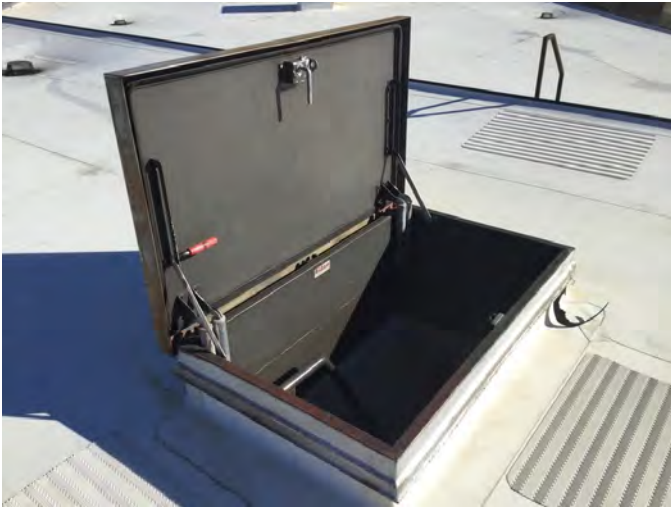
System: B3020 - Roof Openings

Location: Roof
Distress: Beyond Service Life
Category: Deferred Maintenance
Priority: 3 - Necessary/Not Yet Critical (Years 2-5)
Correction: Renew System
Qty: 72,876.00
Unit of Measure: S.F.
Estimate: \$19,239.00
Assessor Name: Eduardo Lopez
Date Created: 01/19/2017

Notes: Roof hatch does not comply with OSHA standards; roof opening protection and proper extension of fixed ladder to platform is not provided.

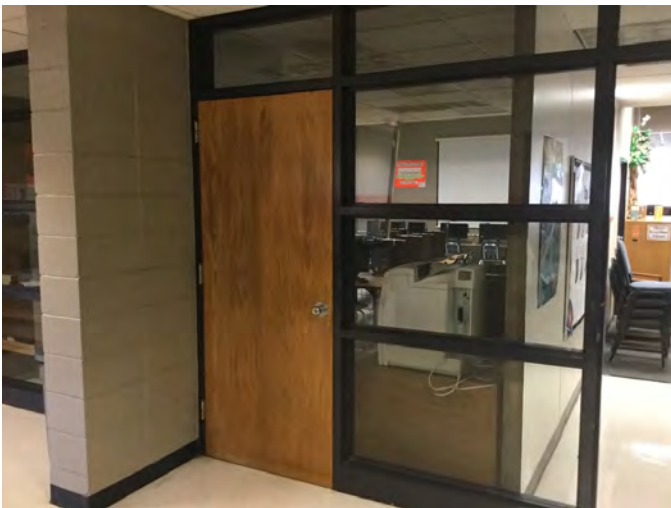
System: C1020 - Interior Doors

Location: Throughout the Building
Distress: Beyond Service Life
Category: Deferred Maintenance / Accessibility Code Compliance
Priority: 3 - Necessary/Not Yet Critical (Years 2-5)
Correction: Renew System
Qty: 72,876.00
Unit of Measure: S.F.
Estimate: \$197,202.00
Assessor Name: Eduardo Lopez
Date Created: 01/19/2017

Notes: The interior doors are aged, failing, hardware is not ADA or code compliant and should be replaced.

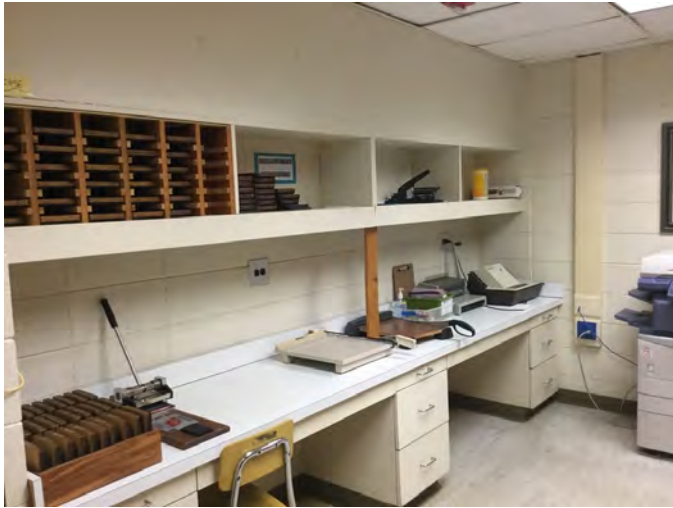
System: E2010 - Fixed Furnishings

Location: Throughout the Building
Distress: Beyond Service Life
Category: Deferred Maintenance
Priority: 3 - Necessary/Not Yet Critical (Years 2-5)
Correction: Renew System
Qty: 72,876.00
Unit of Measure: S.F.
Estimate: \$436,892.00
Assessor Name: Eduardo Lopez
Date Created: 01/19/2017

Notes: The fixed furnishings are aged, in marginal condition, and should be replaced.

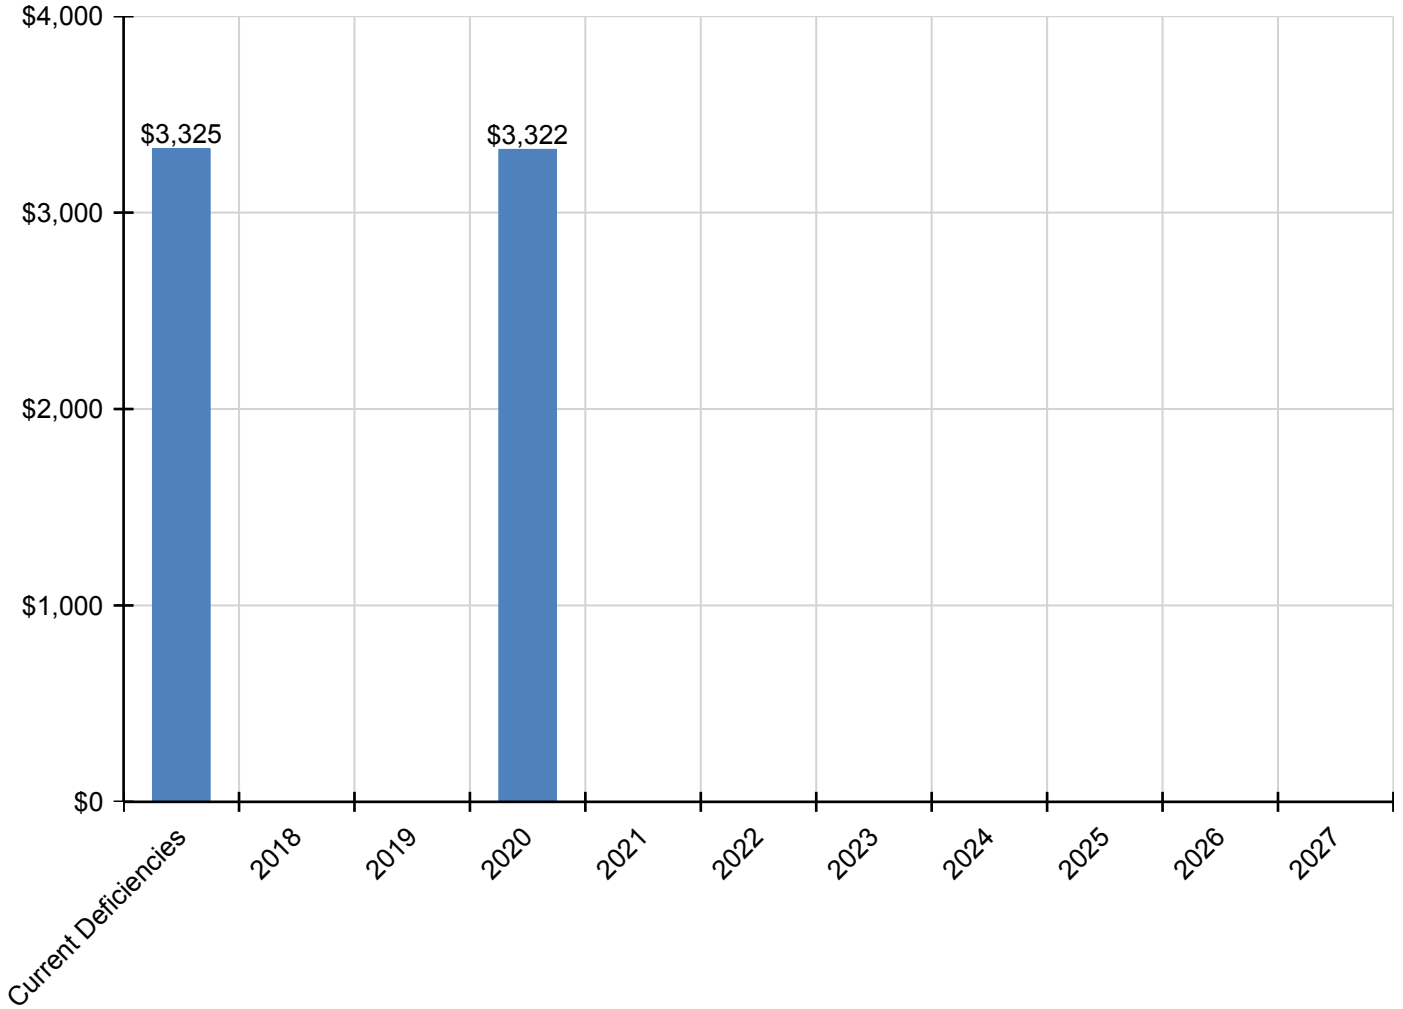
Forecasted Capital Renewal Requirement

The following chart shows the current building deficiencies and forecasting capital renewal or sustainment requirements over the next ten years.

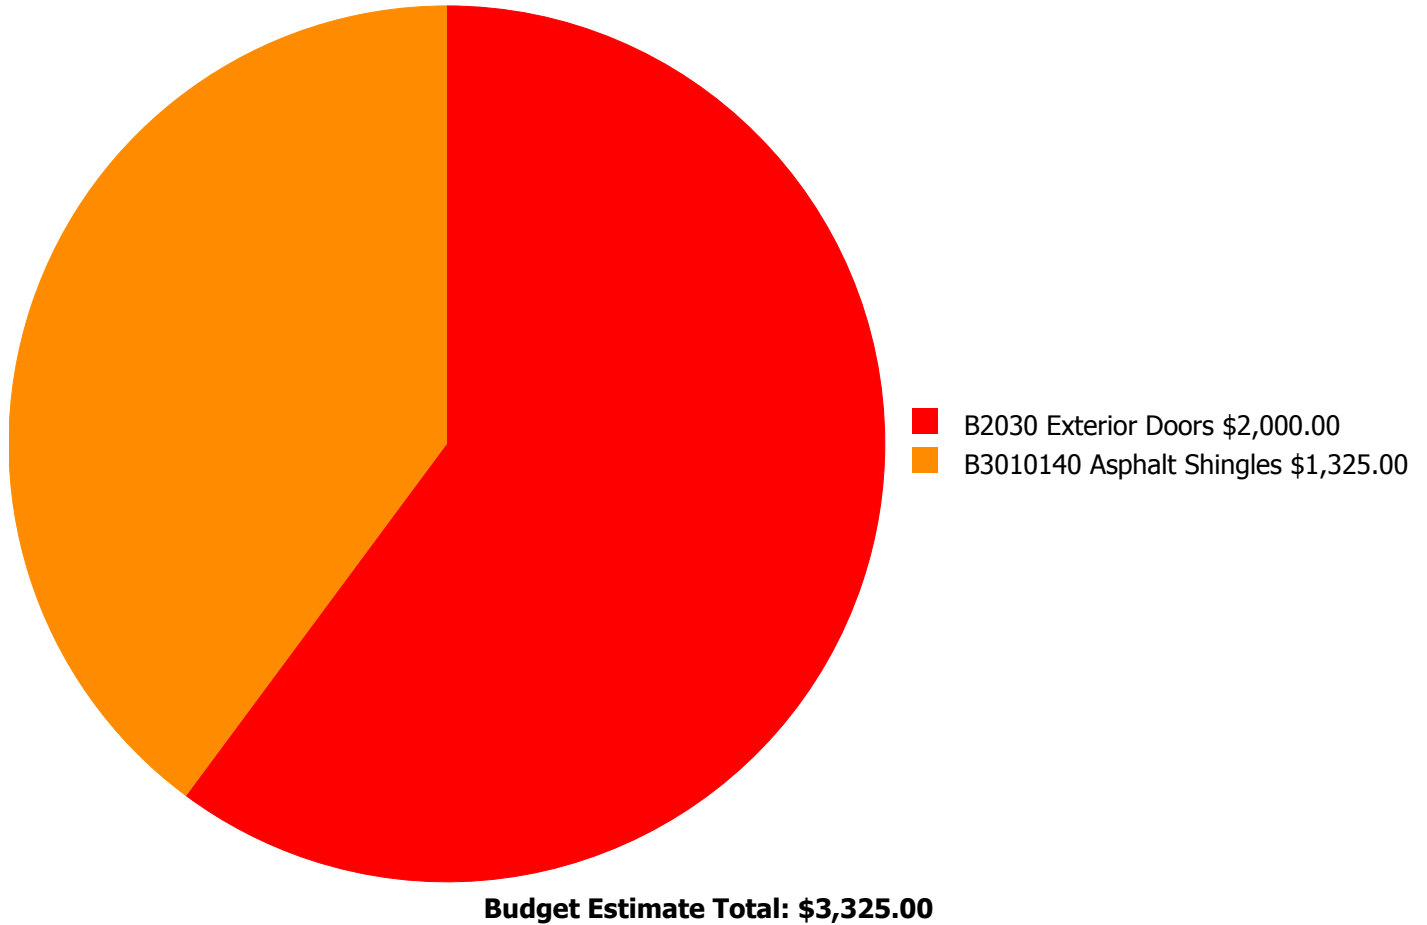
Deficiency Summary by System

Current deficiencies included assemblies that have reached or exceeded their design life or components of the assemblies that are in need of repair. Assemblies that have reached their design life are identified as current deficiencies and assigned the distress 'Beyond Useful Life'. The following chart lists all current deficiencies associated with this facility.

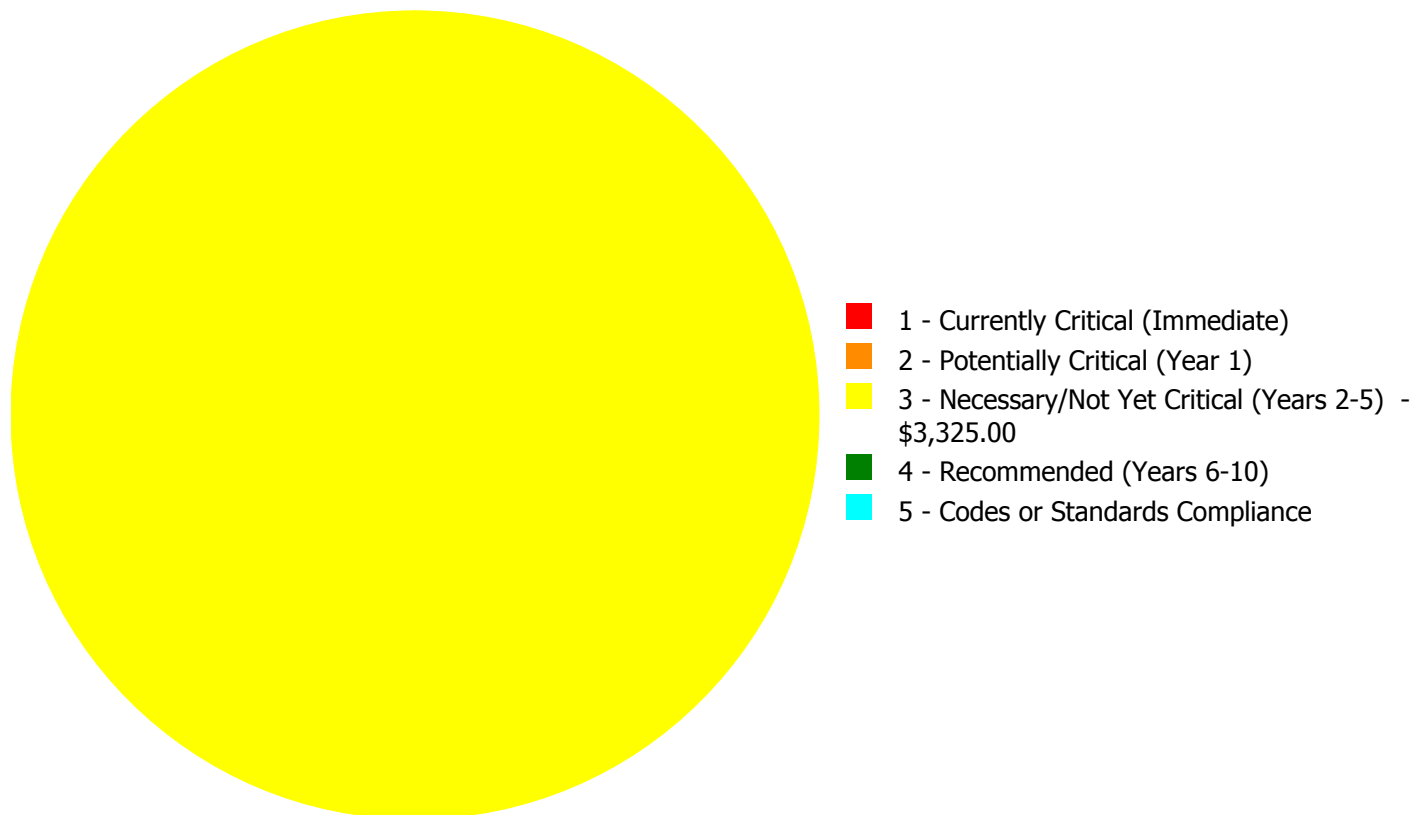
Deficiency Summary by Priority

The following chart shows the total repair costs broken down by priority. Assessors assigned deficiencies within eCOMET to one of the following priority categories:

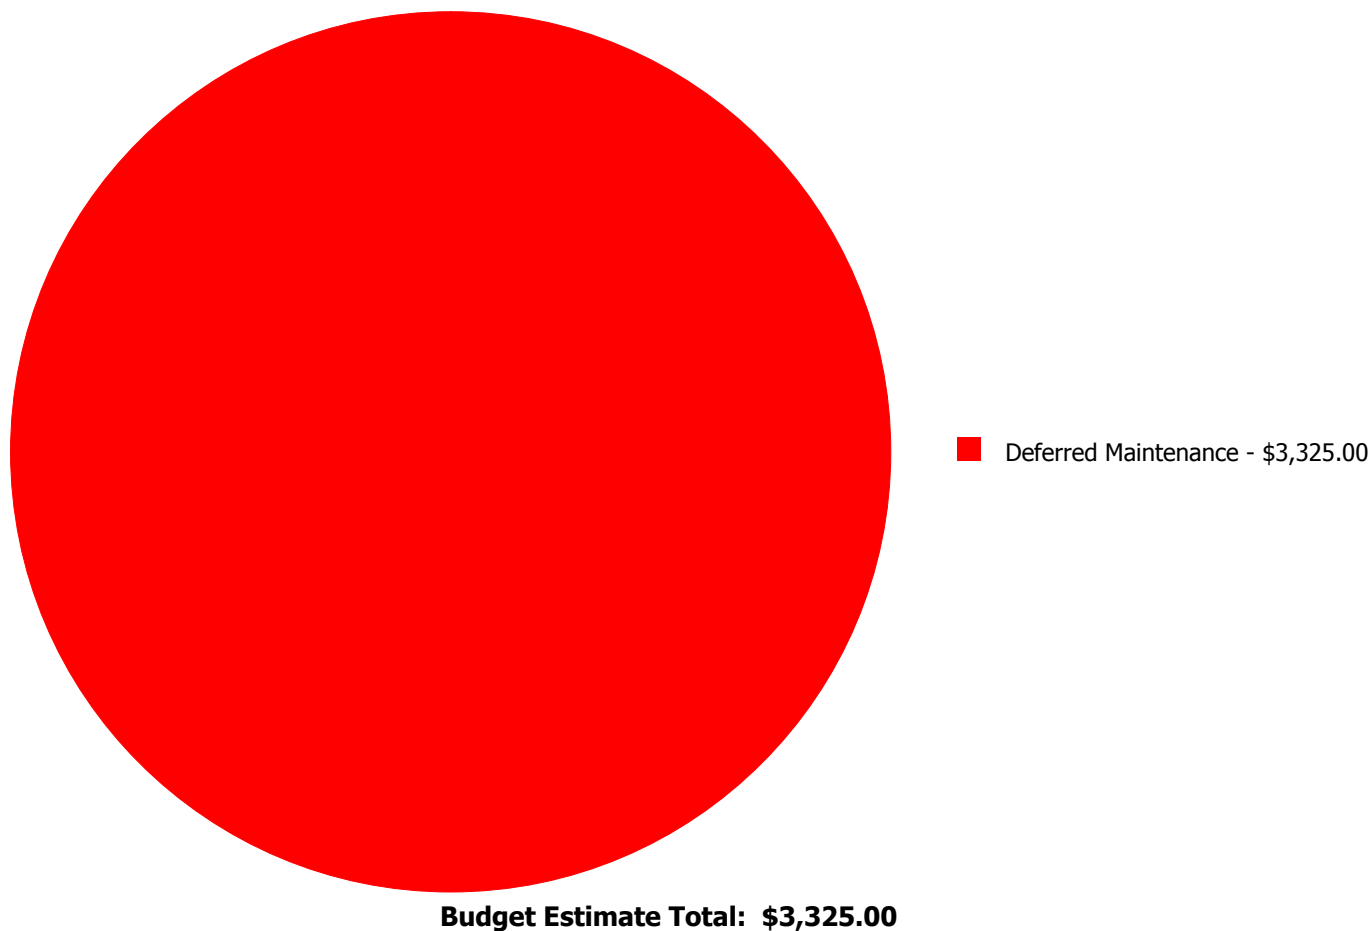
Deficiency Summary by Category

The following chart shows the total repair costs broken down by deficiency categories. Assessors assigned deficiencies to one of the following categories:

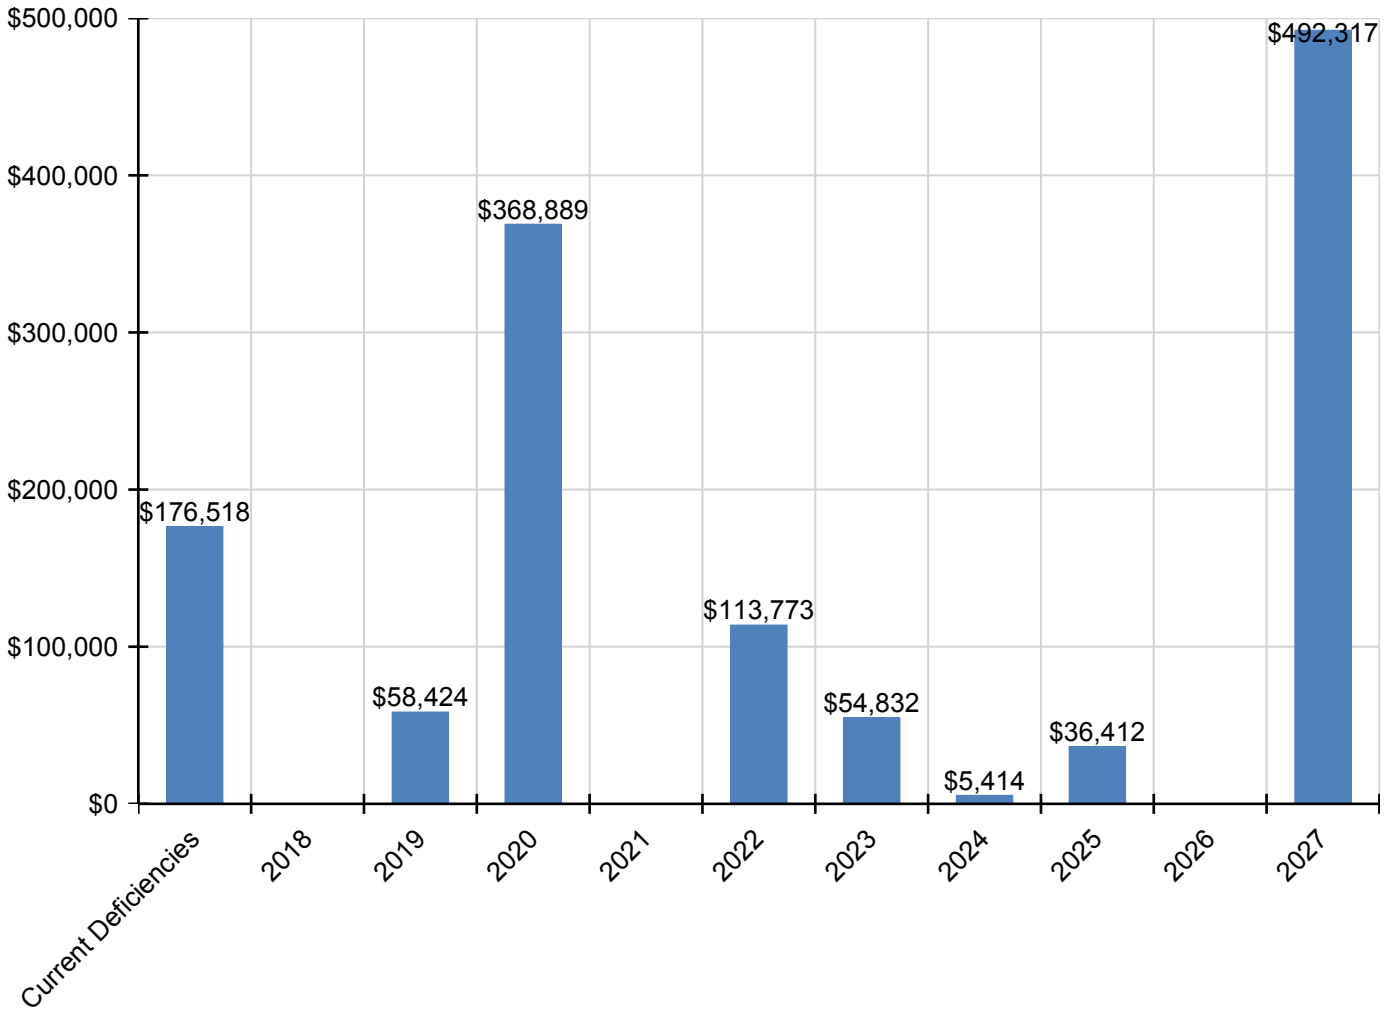
Forecasted Capital Renewal Requirement

The following chart shows the current building deficiencies and forecasting capital renewal or sustainment requirements over the next ten years.

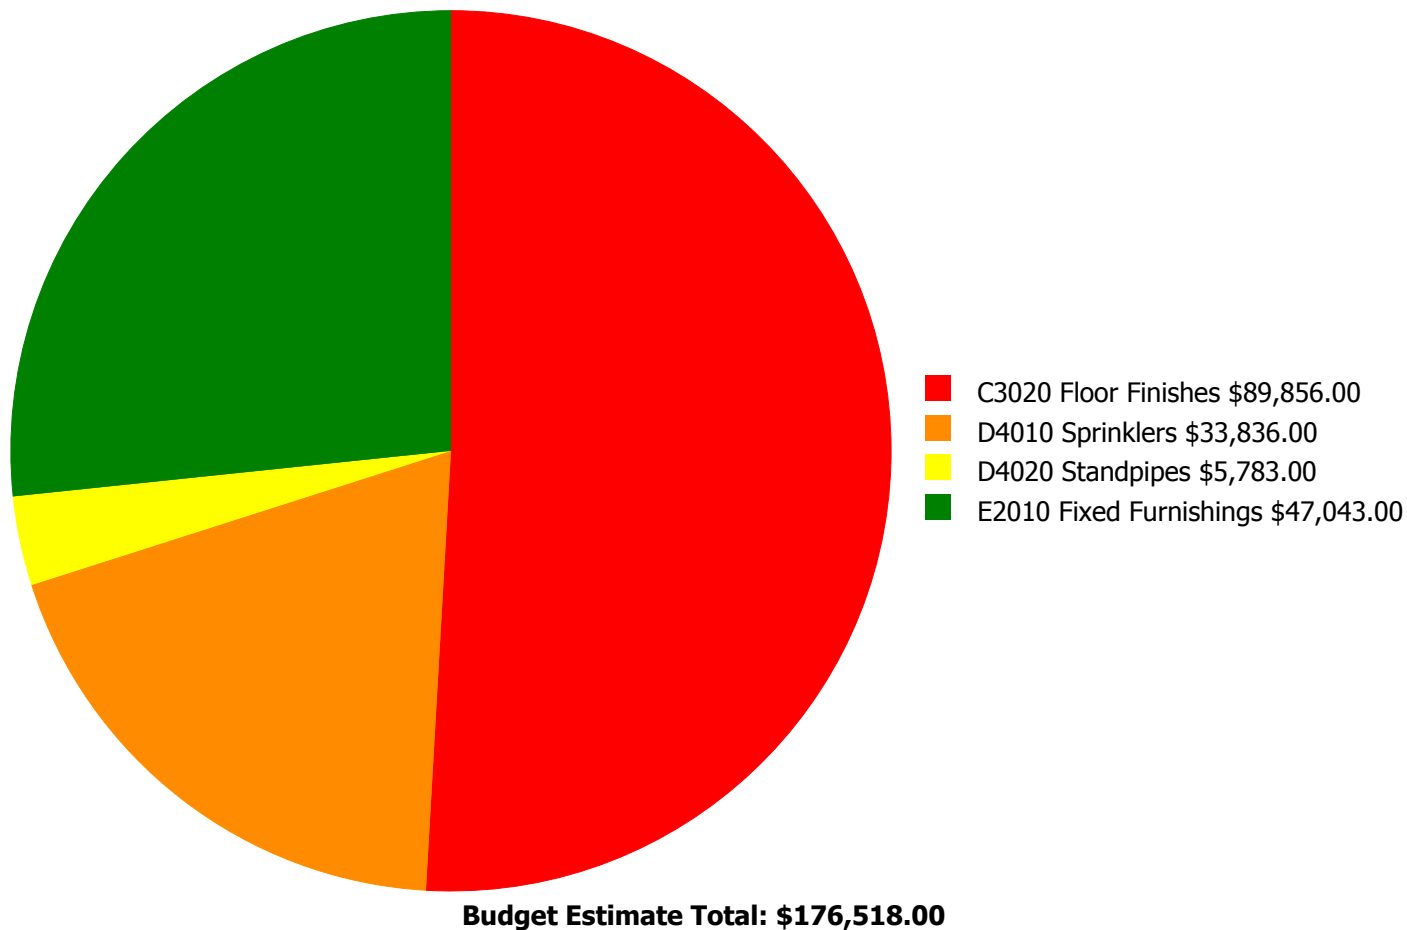
Deficiency Summary by System

Current deficiencies included assemblies that have reached or exceeded their design life or components of the assemblies that are in need of repair. Assemblies that have reached their design life are identified as current deficiencies and assigned the distress 'Beyond Useful Life'. The following chart lists all current deficiencies associated with this facility.

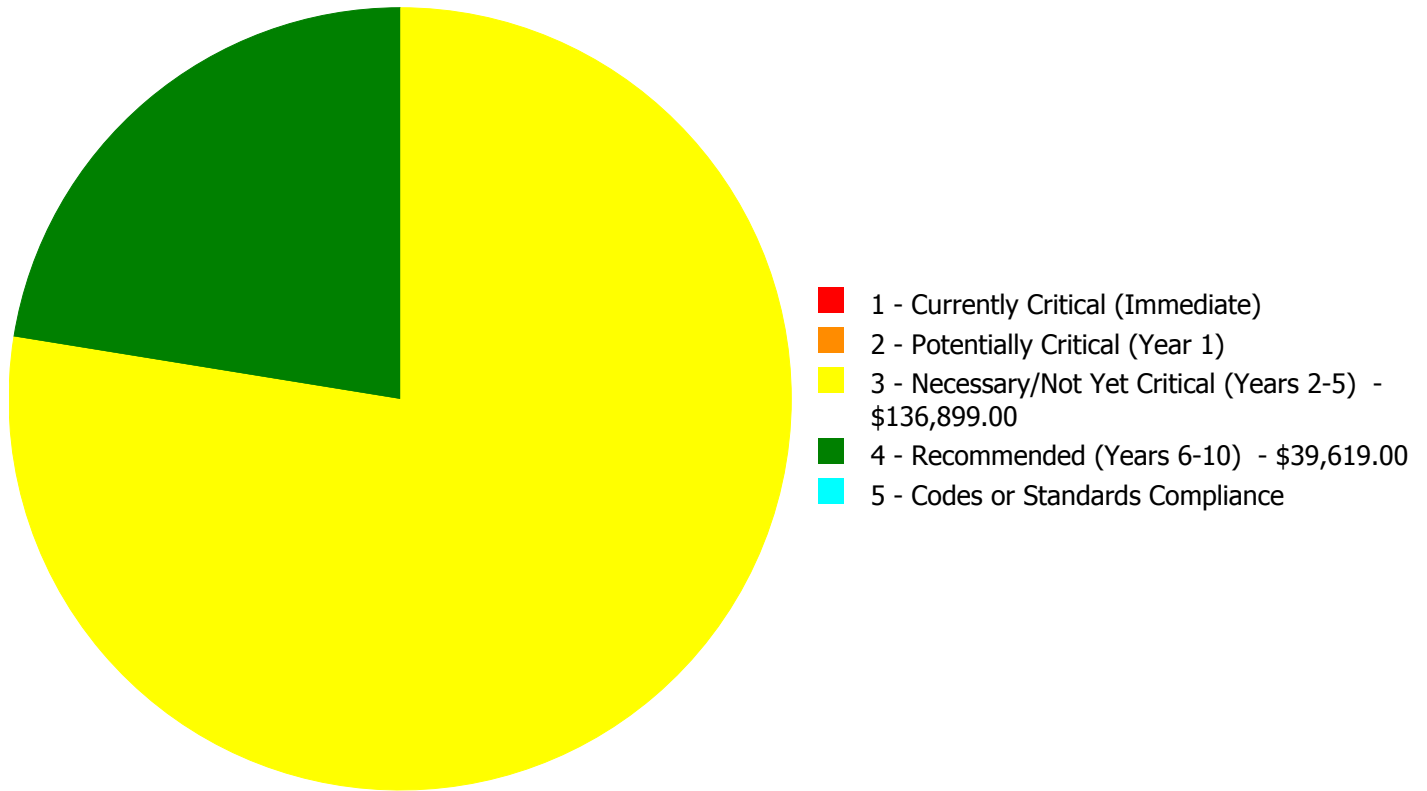
Deficiency Summary by Priority

The following chart shows the total repair costs broken down by priority. Assessors assigned deficiencies within eCOMET to one of the following priority categories:
