NC School District/300 Davie County/High School

Central Davie Academy

Campus Assessment Report

March 7, 2017

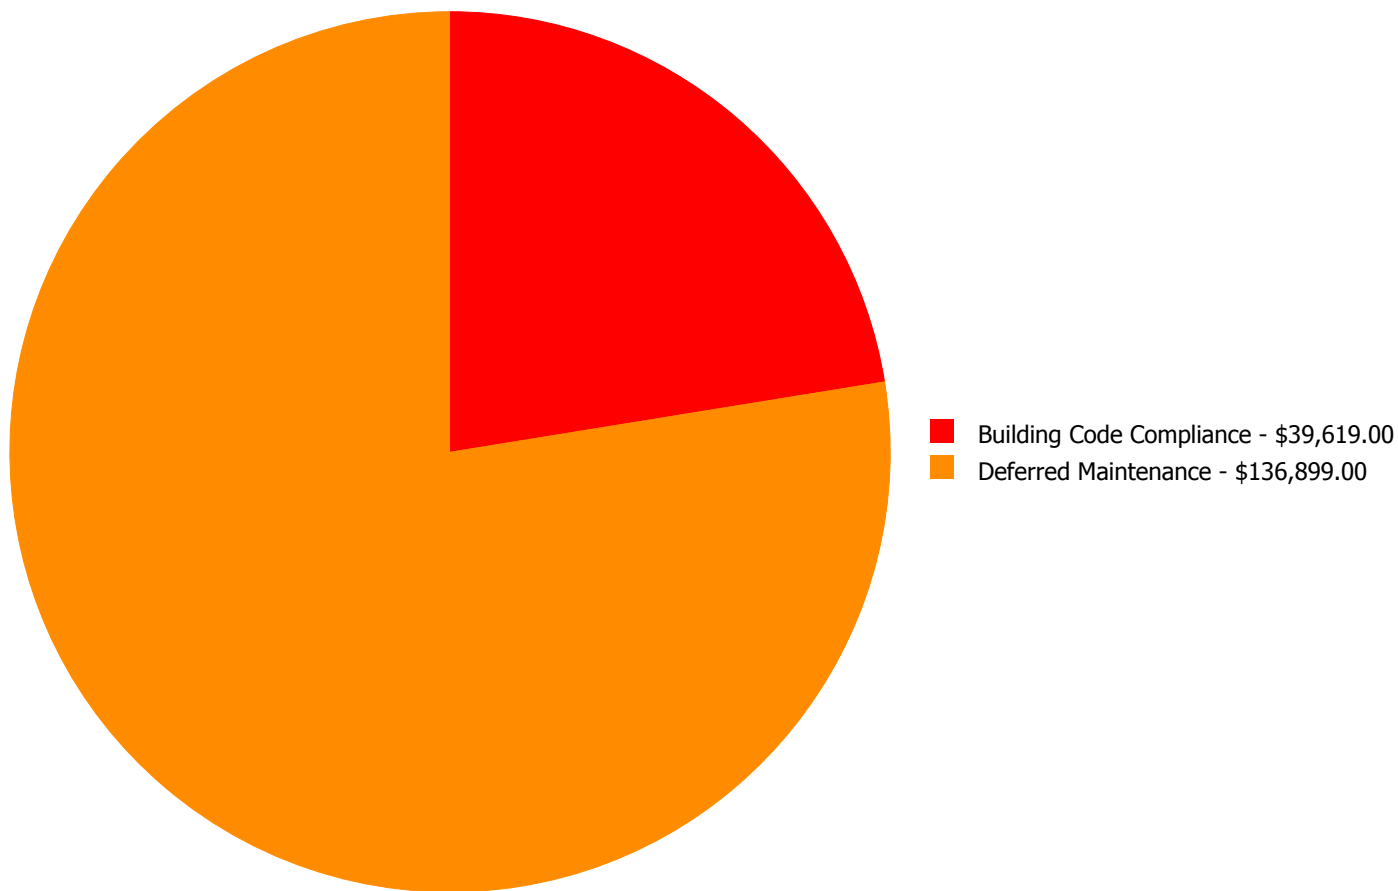
Deficiency Summary by Category

The following chart shows the total repair costs broken down by deficiency categories. Assessors assigned deficiencies to one of the following categories:

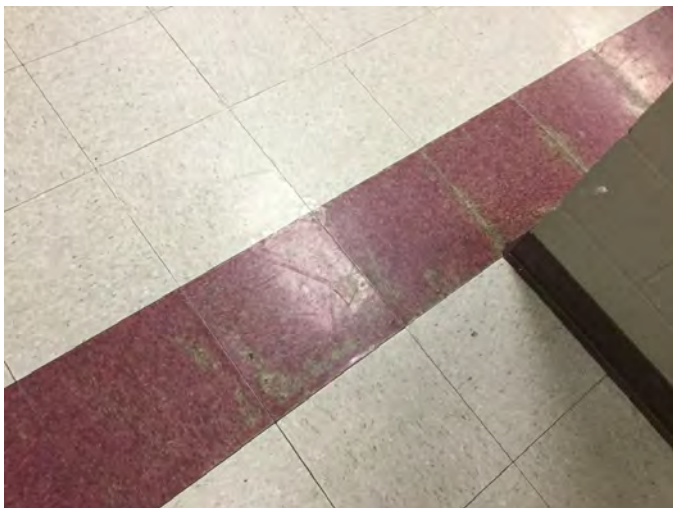
System: C3020 - Floor Finishes

Location: Throughout the Building
Distress: Beyond Service Life
Category: Deferred Maintenance
Priority: 3 - Necessary/Not Yet Critical (Years 2-5)
Correction: Renew System
Qty: 7,847.00
Unit of Measure: S.F.
Estimate: \$89,856.00
Assessor Name: Eduardo Lopez
Date Created: 01/19/2017

Notes: The original flooring is in poor conditions and should be replaced.

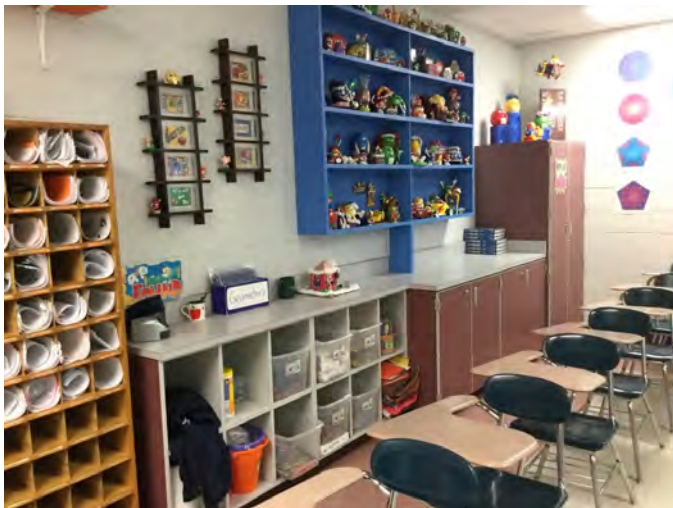
System: E2010 - Fixed Furnishings

Location: Throughout the Building
Distress: Beyond Service Life
Category: Deferred Maintenance
Priority: 3 - Necessary/Not Yet Critical (Years 2-5)
Correction: Renew System
Qty: 7,847.00
Unit of Measure: S.F.
Estimate: \$47,043.00
Assessor Name: Eduardo Lopez
Date Created: 01/19/2017

Notes: The fixed furnishings are aged, in marginal condition, and should be replaced.

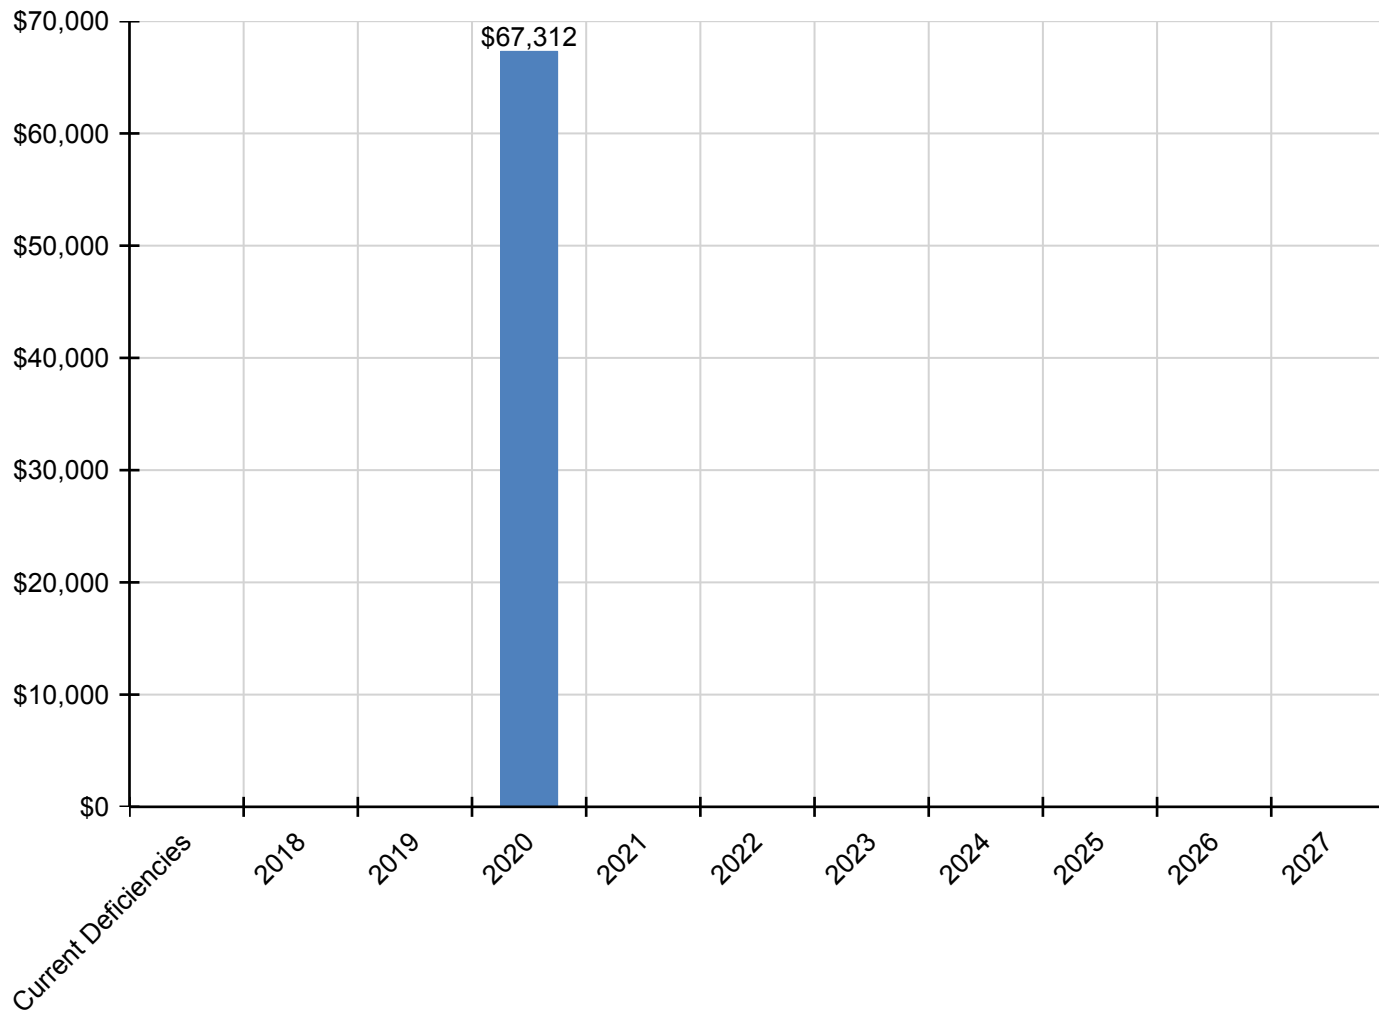
Forecasted Capital Renewal Requirement

The following chart shows the current building deficiencies and forecasting capital renewal or sustainment requirements over the next ten years.

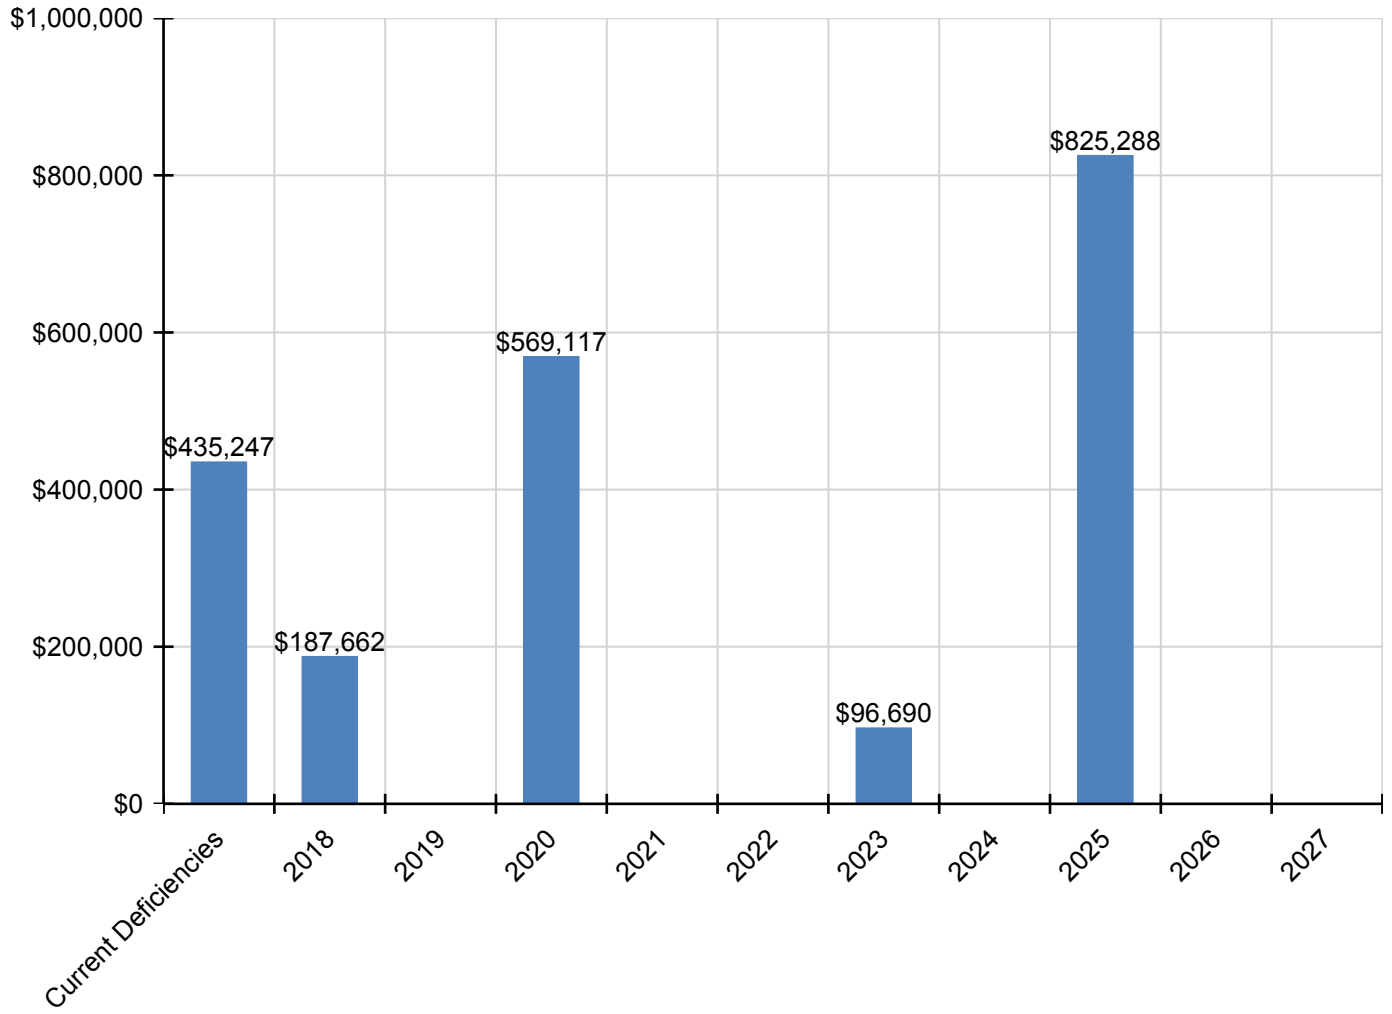
Forecasted Capital Renewal Requirement

The following chart shows the current building deficiencies and forecasting capital renewal or sustainment requirements over the next ten years.

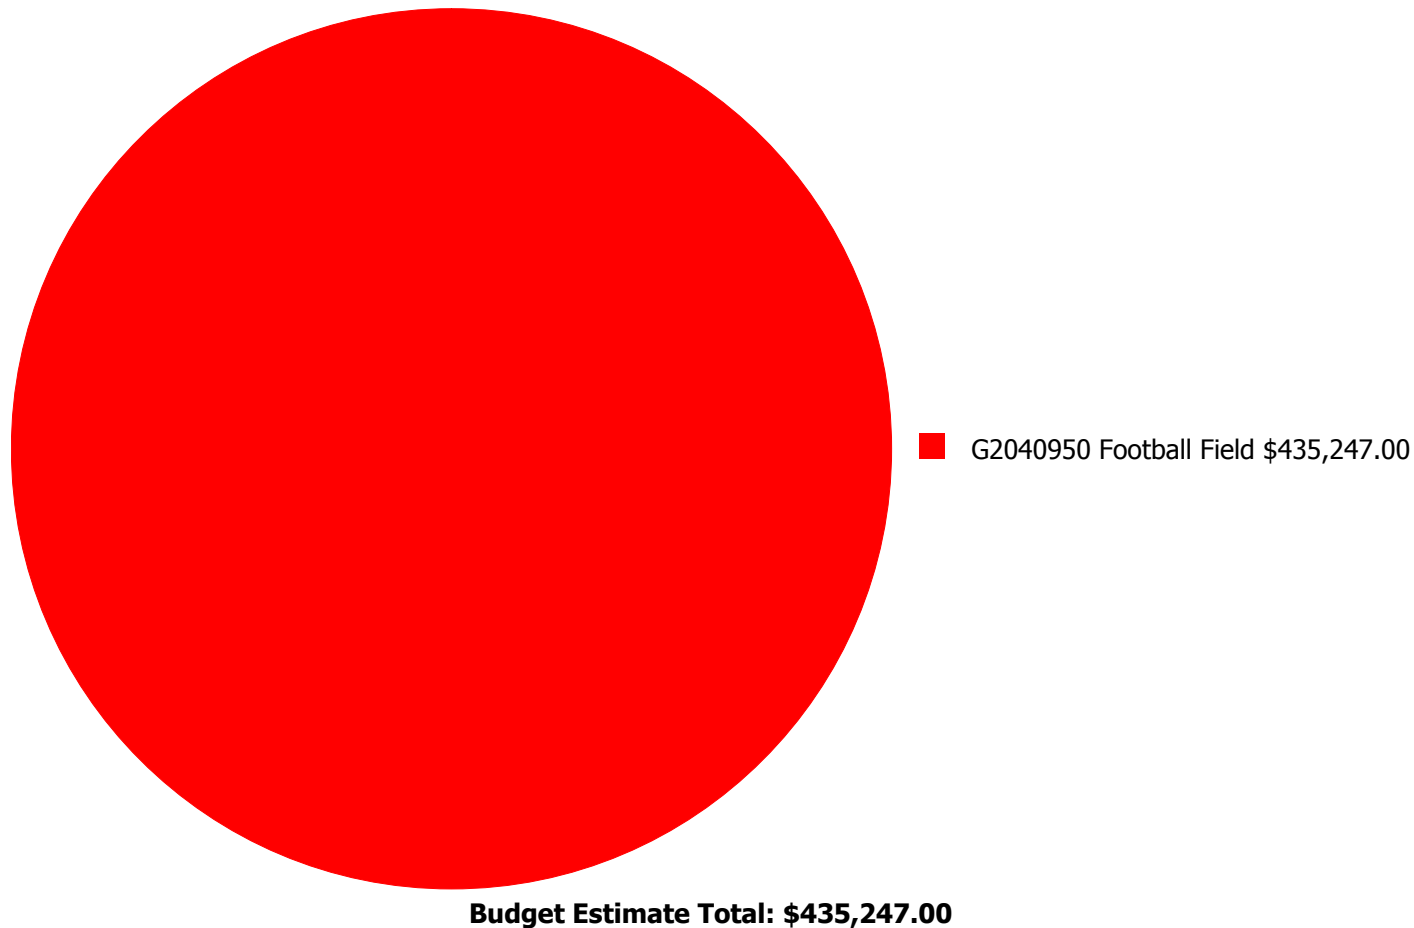
Deficiency Summary by System

Current deficiencies included assemblies that have reached or exceeded their design life or components of the assemblies that are in need of repair. Assemblies that have reached their design life are identified as current deficiencies and assigned the distress 'Beyond Useful Life'. The following chart lists all current deficiencies associated with this facility.

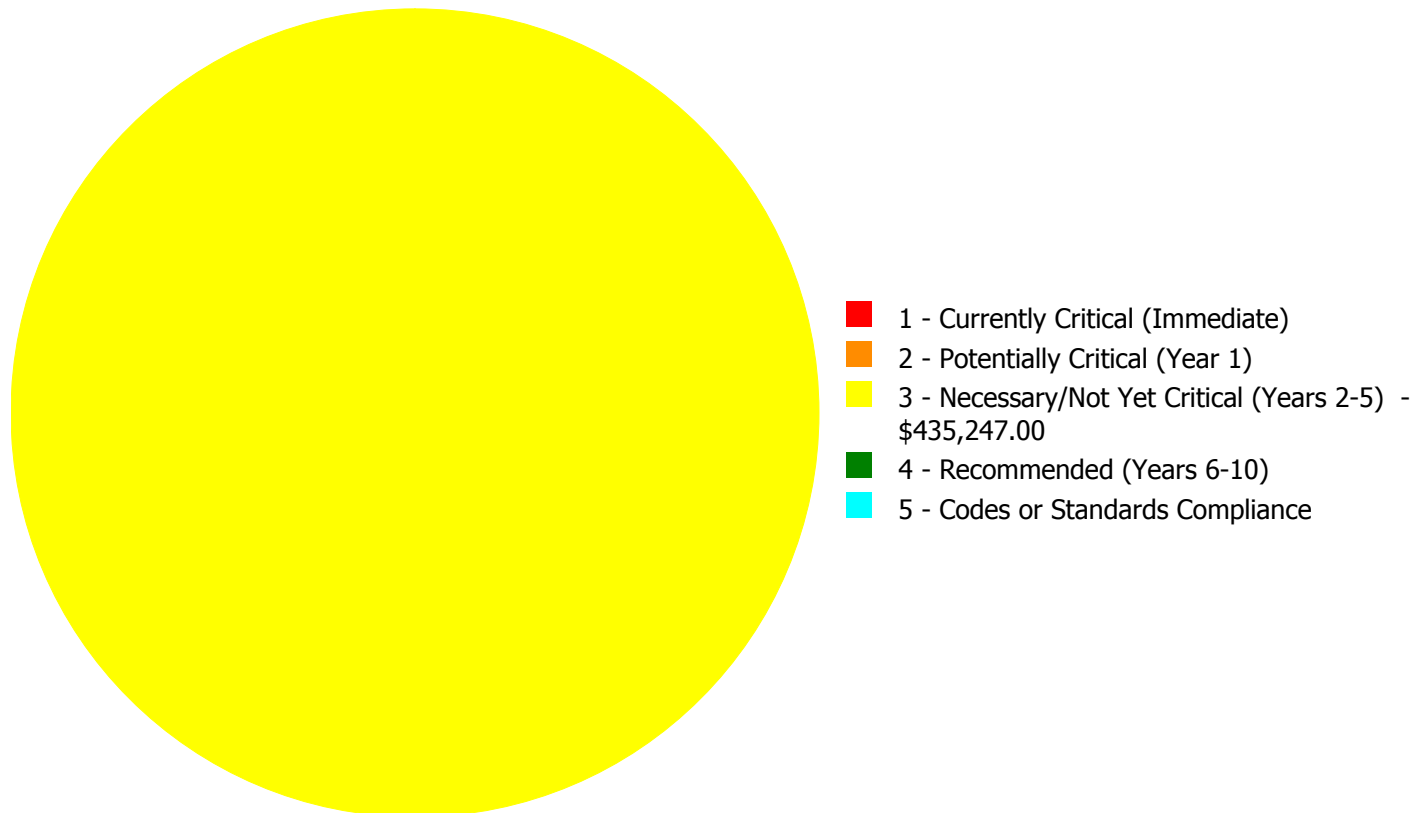
Deficiency Summary by Priority

The following chart shows the total repair costs broken down by priority. Assessors assigned deficiencies within eCOMET to one of the following priority categories:

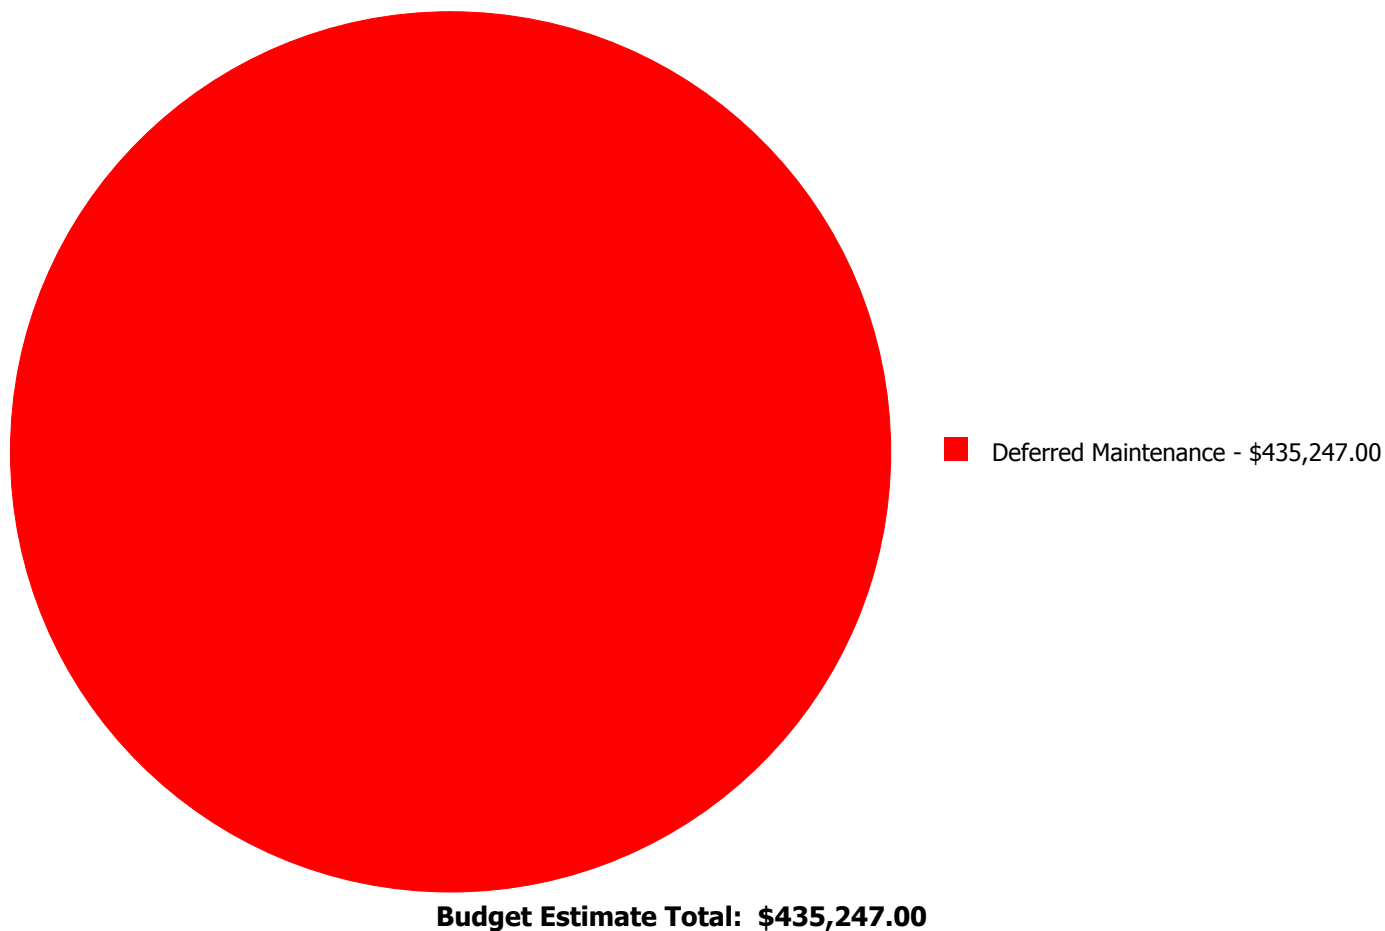
Deficiency Summary by Category

The following chart shows the total repair costs broken down by deficiency categories. Assessors assigned deficiencies to one of the following categories:

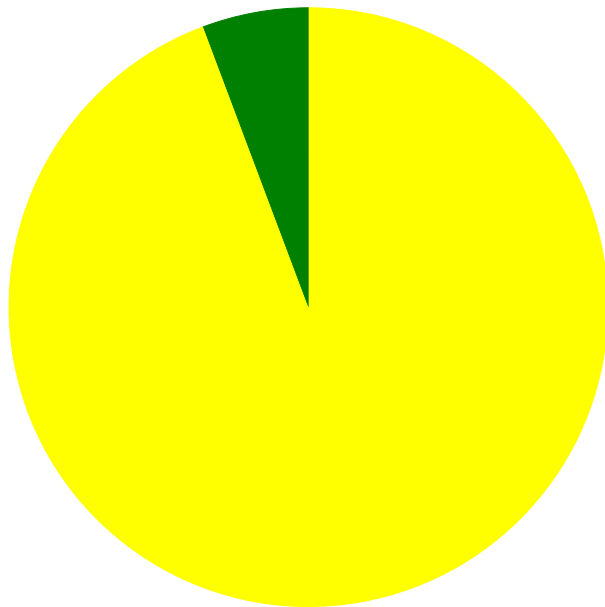
Deficiencies By Priority

- 1 - Currently Critical (Immediate)
- 2 - Potentially Critical (Year 1)
- 3 - Necessary/Not Yet Critical (Years 2-5) - \$7,296,834.44
- 4 - Recommended (Years 6-10) - \$442,743.00
- 5 - Codes or Standards Compliance

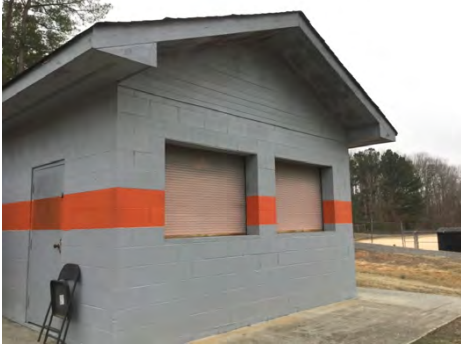
System: B2020 - Exterior Windows

Note: Service counter windows.

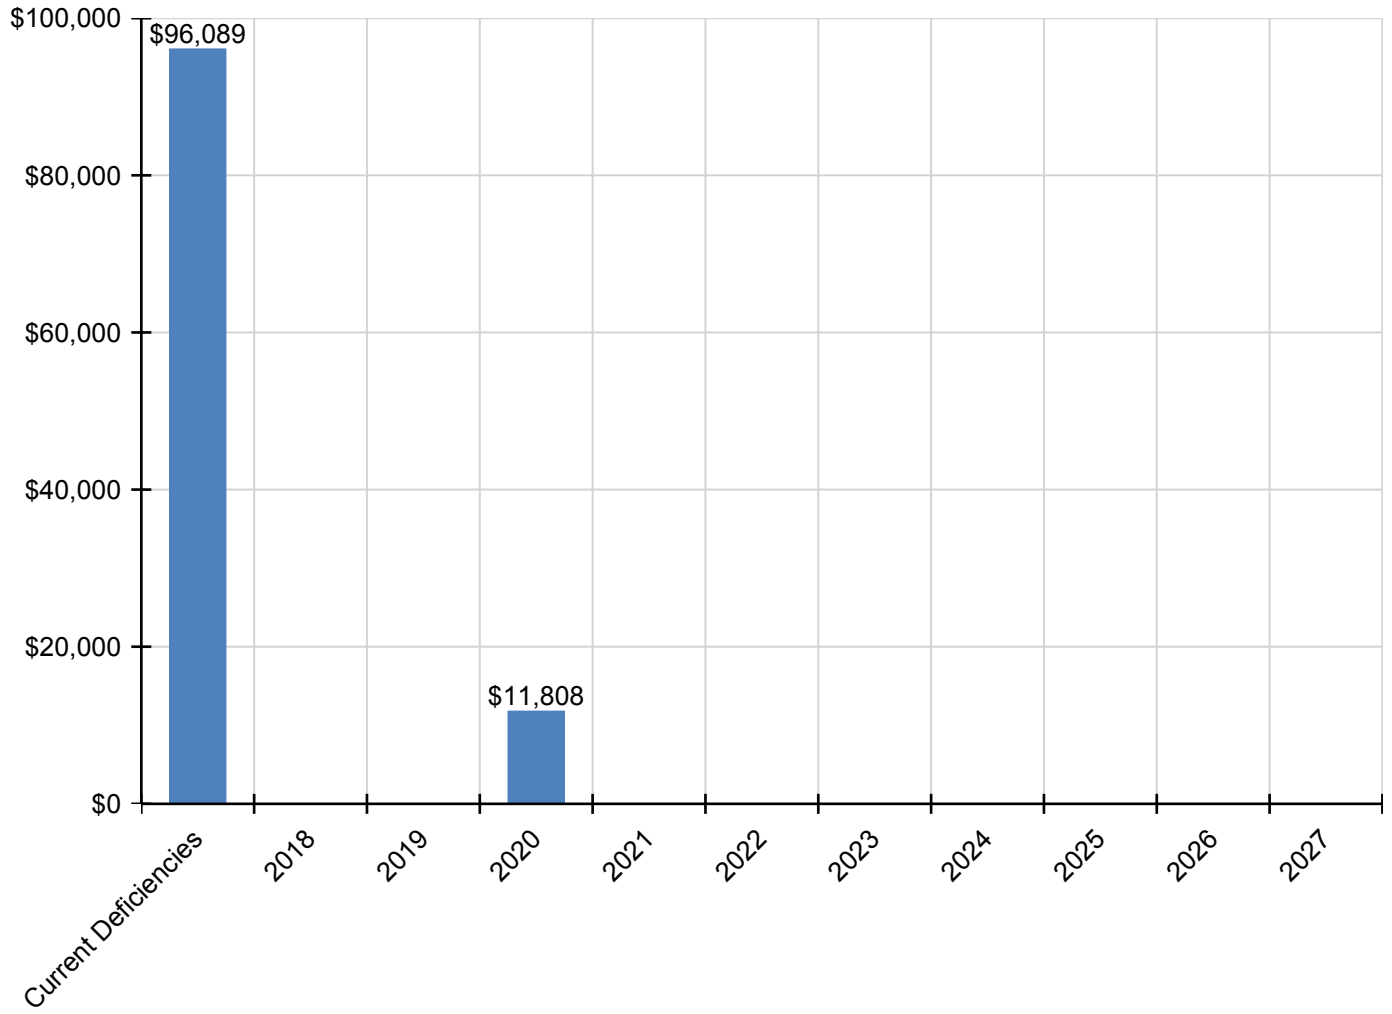
Forecasted Capital Renewal Requirement

The following chart shows the current building deficiencies and forecasting capital renewal or sustainment requirements over the next ten years.

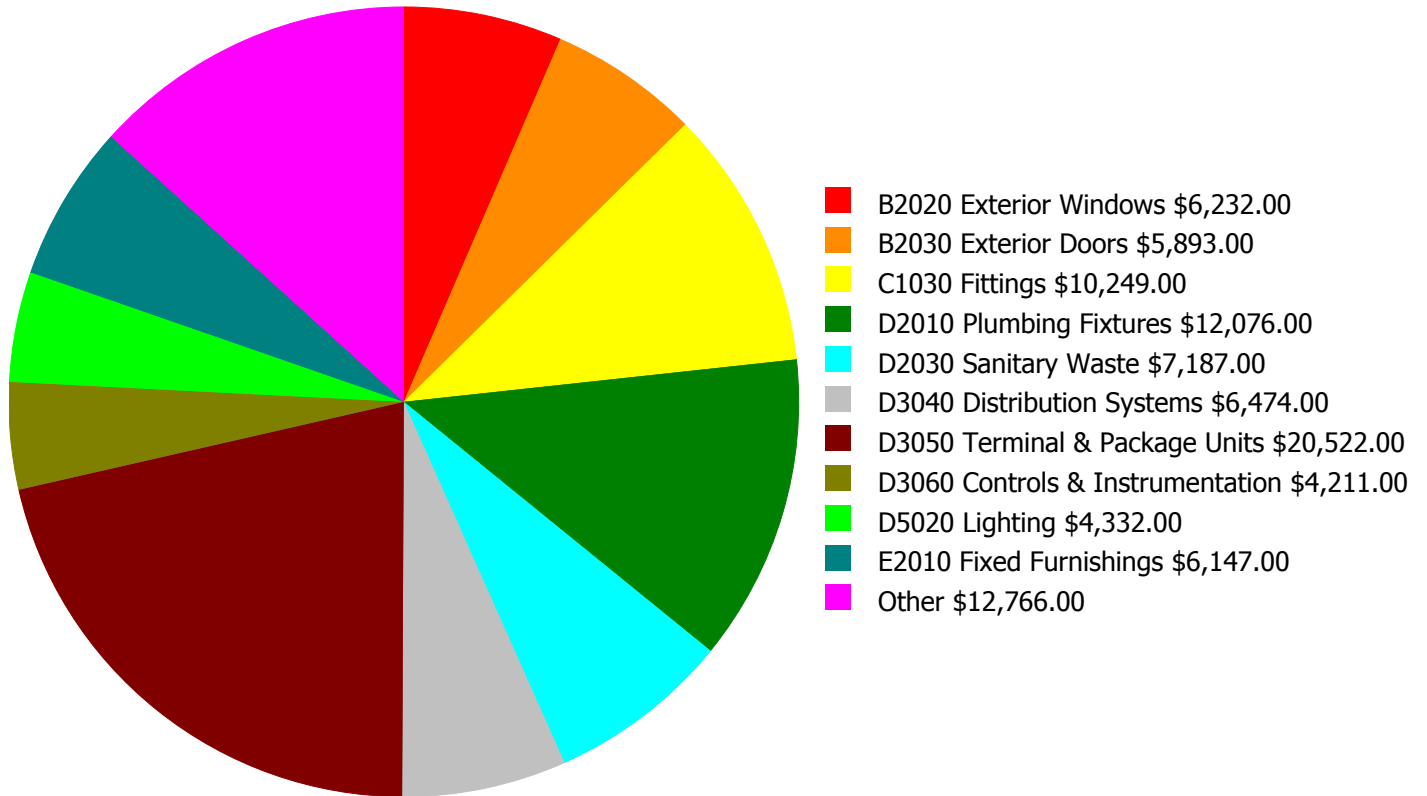
Deficiency Summary by System

Current deficiencies included assemblies that have reached or exceeded their design life or components of the assemblies that are in need of repair. Assemblies that have reached their design life are identified as current deficiencies and assigned the distress 'Beyond Useful Life'. The following chart lists all current deficiencies associated with this facility.

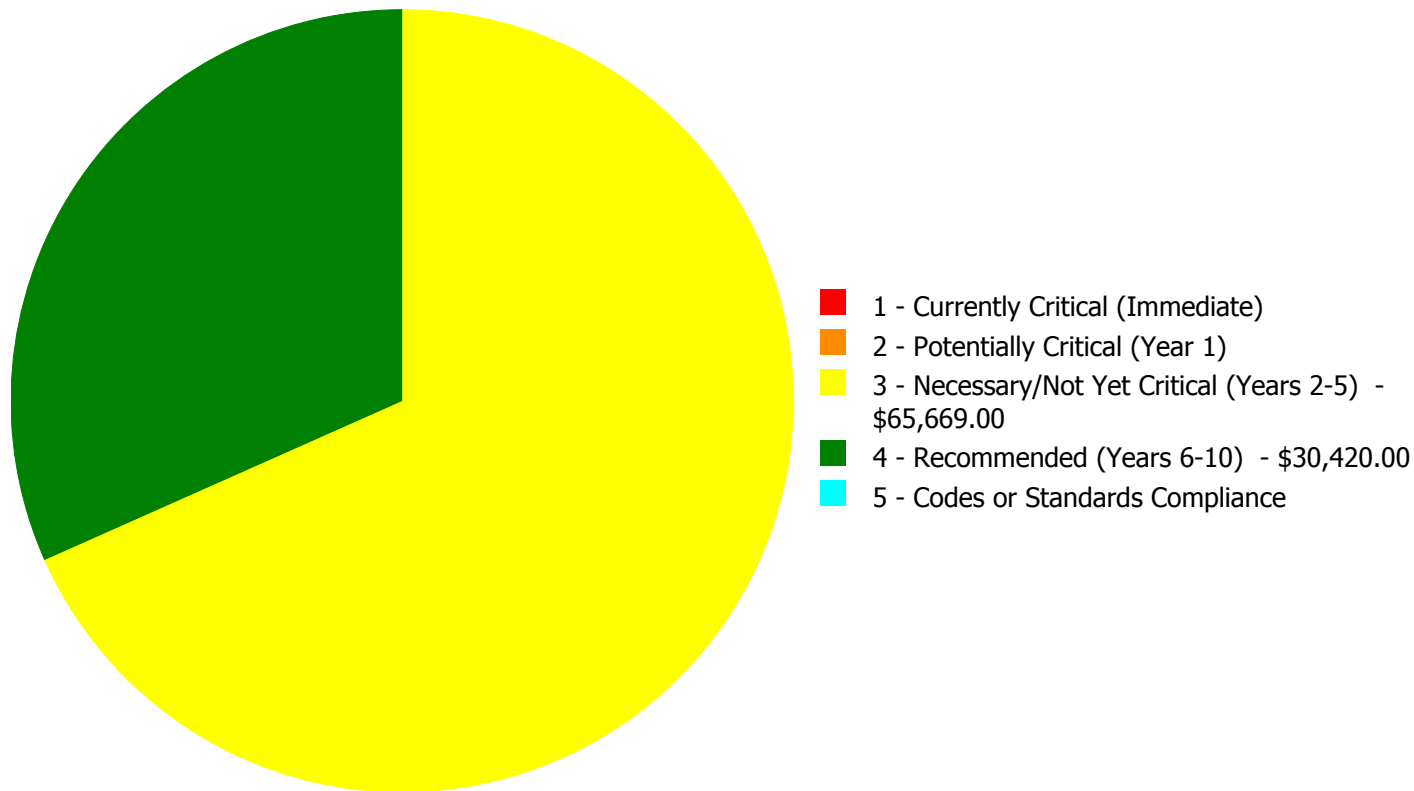
Deficiency Summary by Priority

The following chart shows the total repair costs broken down by priority. Assessors assigned deficiencies within eCOMET to one of the following priority categories:

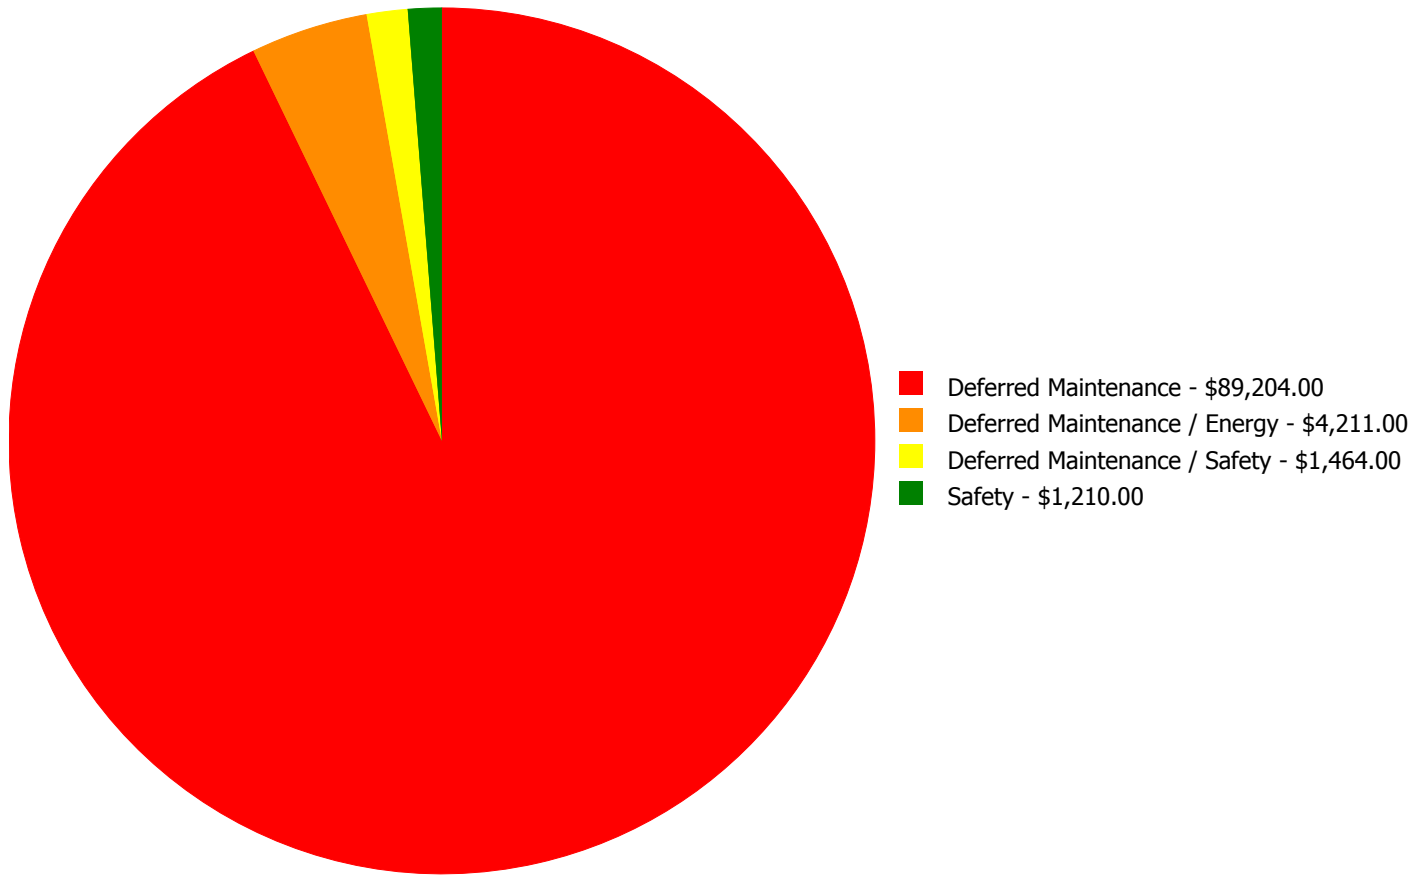
Deficiency Summary by Category

The following chart shows the total repair costs broken down by deficiency categories. Assessors assigned deficiencies to one of the following categories:

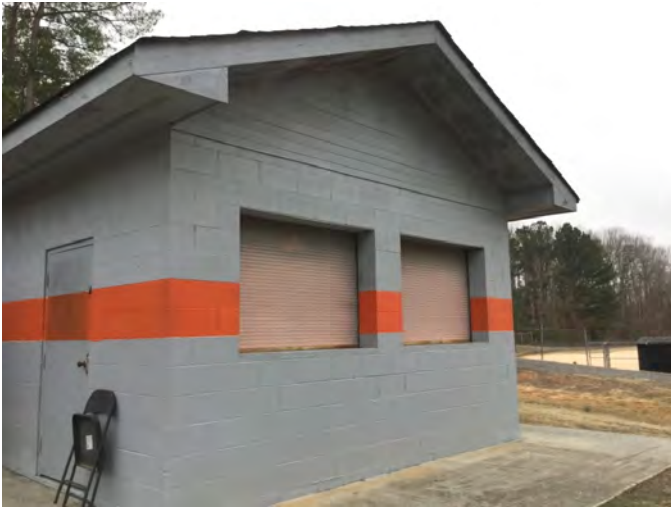
System: B2020 - Exterior Windows

Location: Concessions
Distress: Beyond Service Life
Category: Deferred Maintenance
Priority: 3 - Necessary/Not Yet Critical (Years 2-5)
Correction: Renew System
Qty: 1,100.00
Unit of Measure: S.F.
Estimate: \$6,232.00
Assessor Name: Eduardo Lopez
Date Created: 01/24/2017

Notes: Service counter windows are beyond their expected useful life.

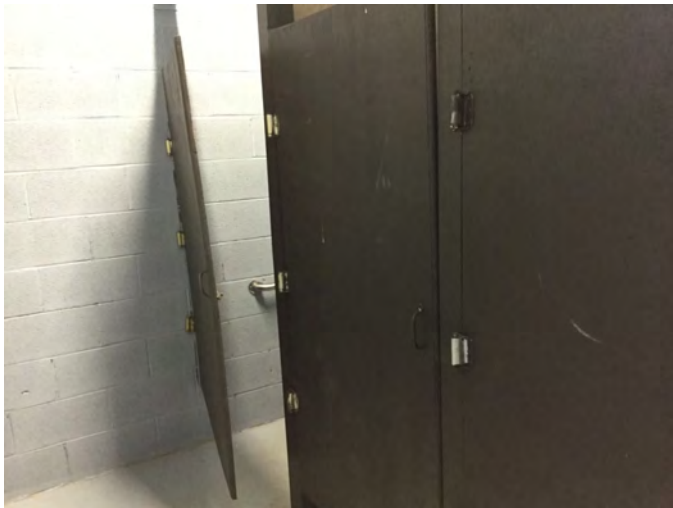
System: C1030 - Fittings

Location: Throughout the building
Distress: Beyond Service Life
Category: Deferred Maintenance
Priority: 3 - Necessary/Not Yet Critical (Years 2-5)
Correction: Renew System
Qty: 1,100.00
Unit of Measure: S.F.
Estimate: \$10,249.00
Assessor Name: Eduardo Lopez
Date Created: 01/23/2017

Notes: Building fittings including toilet partitions and accessories are in marginal condition. Building signage is inadequate. System renewal is recommended.

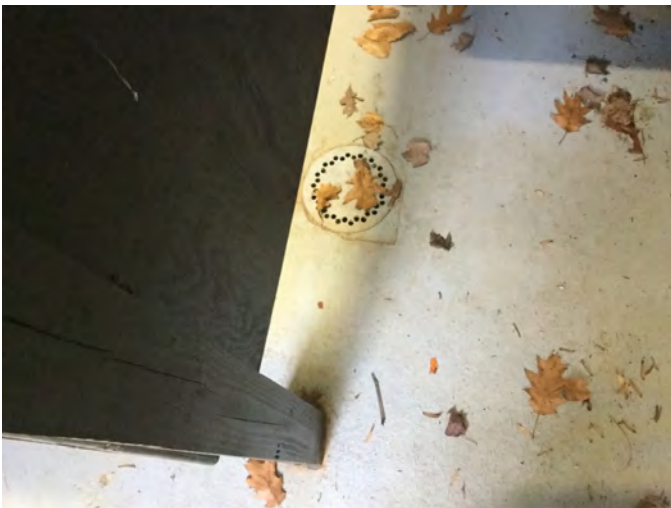
System: D2030 - Sanitary Waste

Location: Toilet rooms and concessions
Distress: Beyond Service Life
Category: Deferred Maintenance
Priority: 3 - Necessary/Not Yet Critical (Years 2-5)
Correction: Renew System
Qty: 1,100.00
Unit of Measure: S.F.
Estimate: \$7,187.00
Assessor Name: Eduardo Lopez
Date Created: 01/23/2017

Notes: The sanitary waste systems has exceeded its expected life. System renewal is recommended.

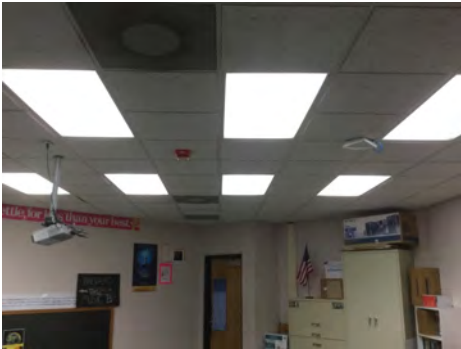
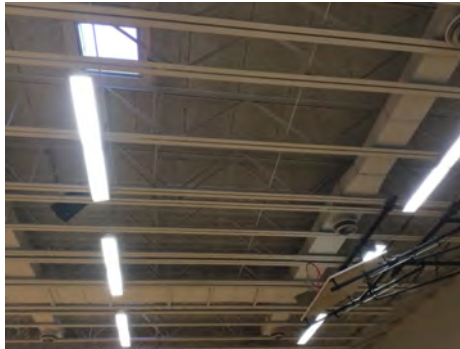
System: C3030 - Ceiling Finishes

Note: Ceiling finishes are generally well maintained in fair to good condition. A few water stained tiles noted should be replaced on a maintenance basis. System renewal put at 5 years hence.

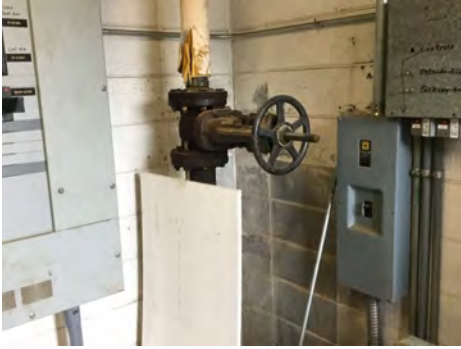
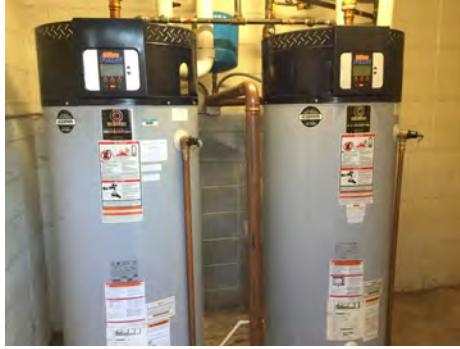
System: D2020 - Domestic Water Distribution

Note: Water heater manufacture dates are 2010 and 2012.

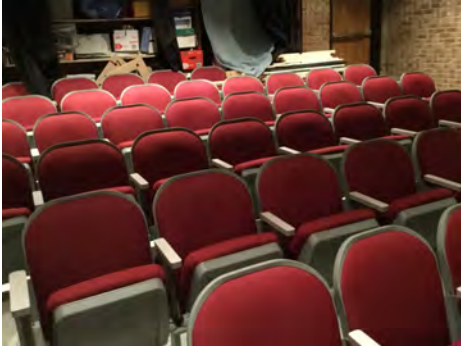
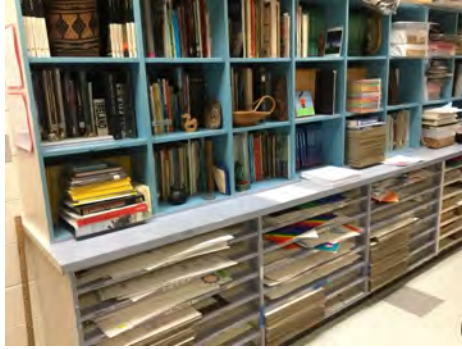
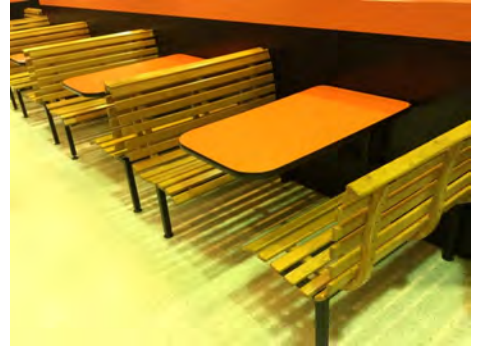
System: E2010 - Fixed Furnishings

Note: Auditorium seating looks new/not original. Estimated install date.

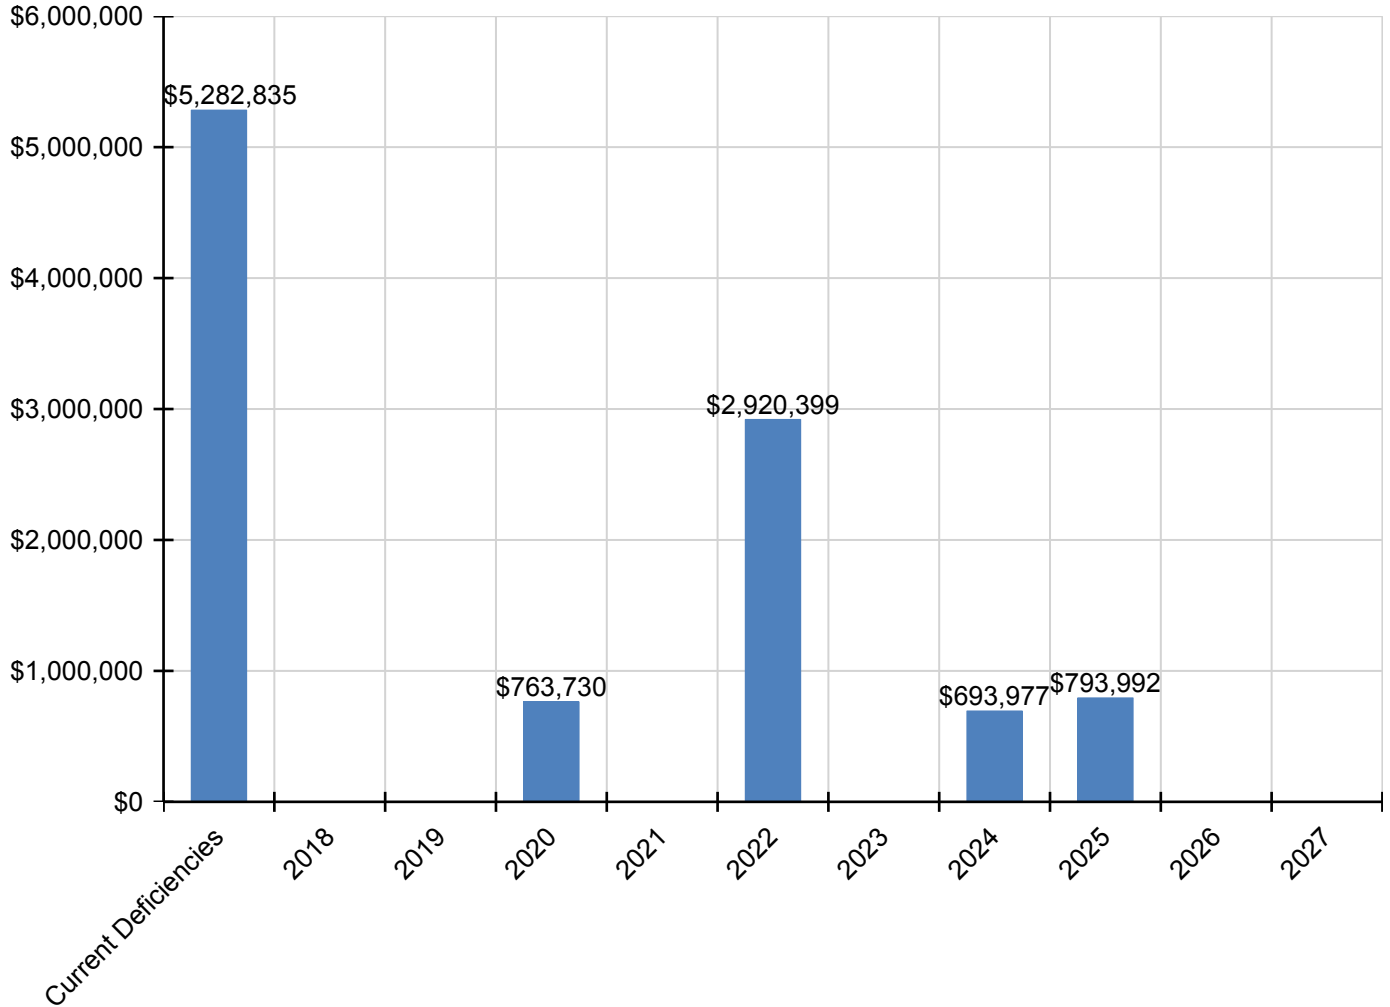
Forecasted Capital Renewal Requirement

The following chart shows the current building deficiencies and forecasting capital renewal or sustainment requirements over the next ten years.

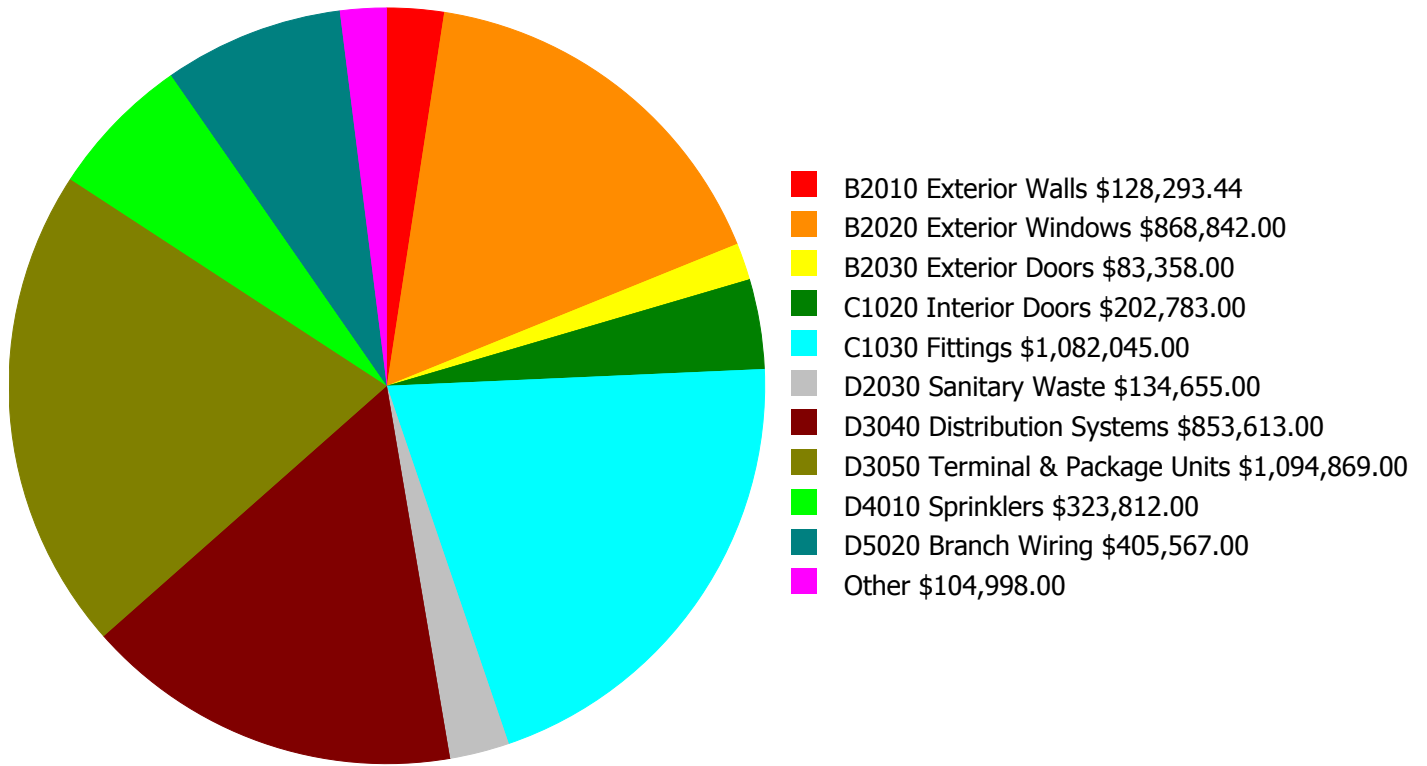
Deficiency Summary by System

Current deficiencies included assemblies that have reached or exceeded their design life or components of the assemblies that are in need of repair. Assemblies that have reached their design life are identified as current deficiencies and assigned the distress 'Beyond Useful Life'. The following chart lists all current deficiencies associated with this facility.

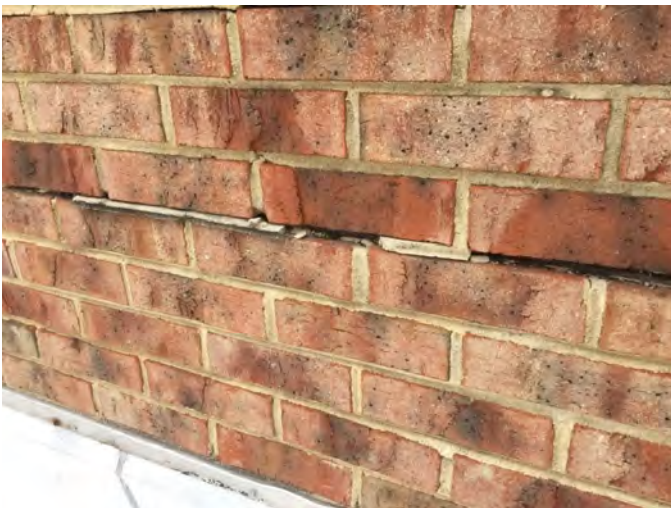
System: B2010 - Exterior Walls

Location: Walls around gym roof, various places around building
Distress: Failing
Category: Deferred Maintenance
Priority: 3 - Necessary/Not Yet Critical (Years 2-5)
Correction: Point clay brick wall, 1st floor
Qty: 10,000.00
Unit of Measure: C.S.F.
Estimate: \$128,293.44
Assessor Name: Somnath Das
Date Created: 01/25/2017

Notes: Brick mortar is deteriorated around gym high walls above roof, particularly at shelf angles. Stairstep cracks in brick mortar noted around openings at front of building, e.g. room 110, and some at rear of building in vicinity of the cafeteria. No significant settlement observed. Brick repairs recommended.

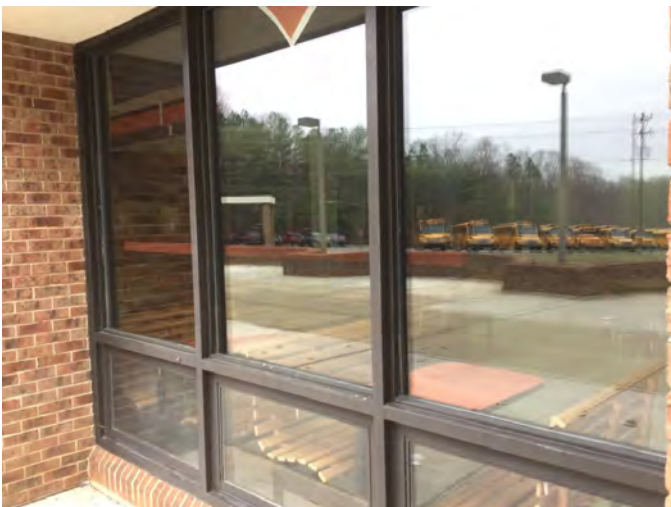
System: B2020 - Exterior Windows

Location: Exterior windows throughout
Distress: Beyond Service Life
Category: Deferred Maintenance
Priority: 3 - Necessary/Not Yet Critical (Years 2-5)
Correction: Renew System
Qty: 72,865.00
Unit of Measure: S.F.
Estimate: \$868,842.00
Assessor Name: Somnath Das
Date Created: 01/24/2017

Notes: The hollow metal steel frame, operable and fixed dual pane windows are well maintained in fair condition. As they are beyond their expected service life, system renewal is recommended.

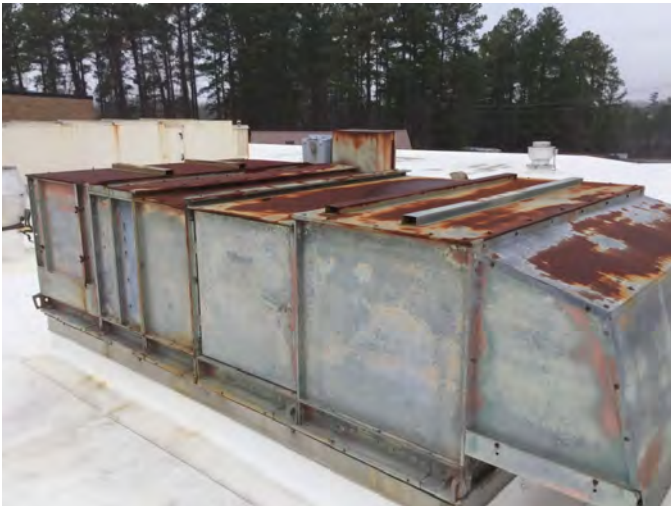
System: D3040 - Distribution Systems

Location: Throughout the building
Distress: Beyond Service Life
Category: Deferred Maintenance
Priority: 3 - Necessary/Not Yet Critical (Years 2-5)
Correction: Renew System
Qty: 72,865.00
Unit of Measure: S.F.
Estimate: \$853,613.00
Assessor Name: Somnath Das
Date Created: 01/24/2017

Notes: HVAC Distribution systems are typically original and include fiber lined ductwork. System renewal is recommended.

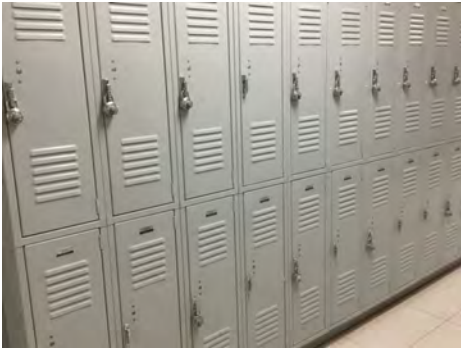
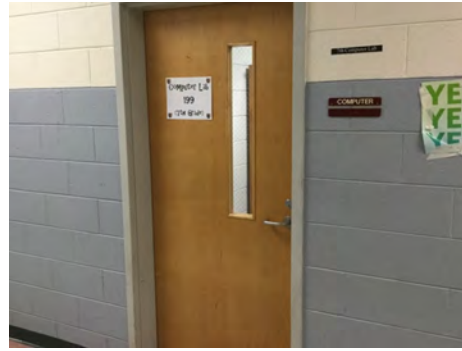
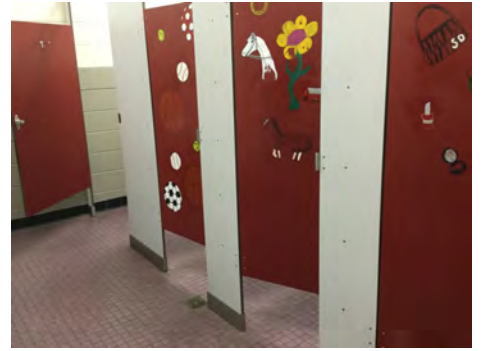
System: C1030 - Fittings

Note: Toilet partitions appear to be newer. Signage is up to code. Lockers are in good condition. System life given 5 more years.
