NC School District/300 Davie County/High School

Central Davie Academy

Campus Assessment Report

March 7, 2017

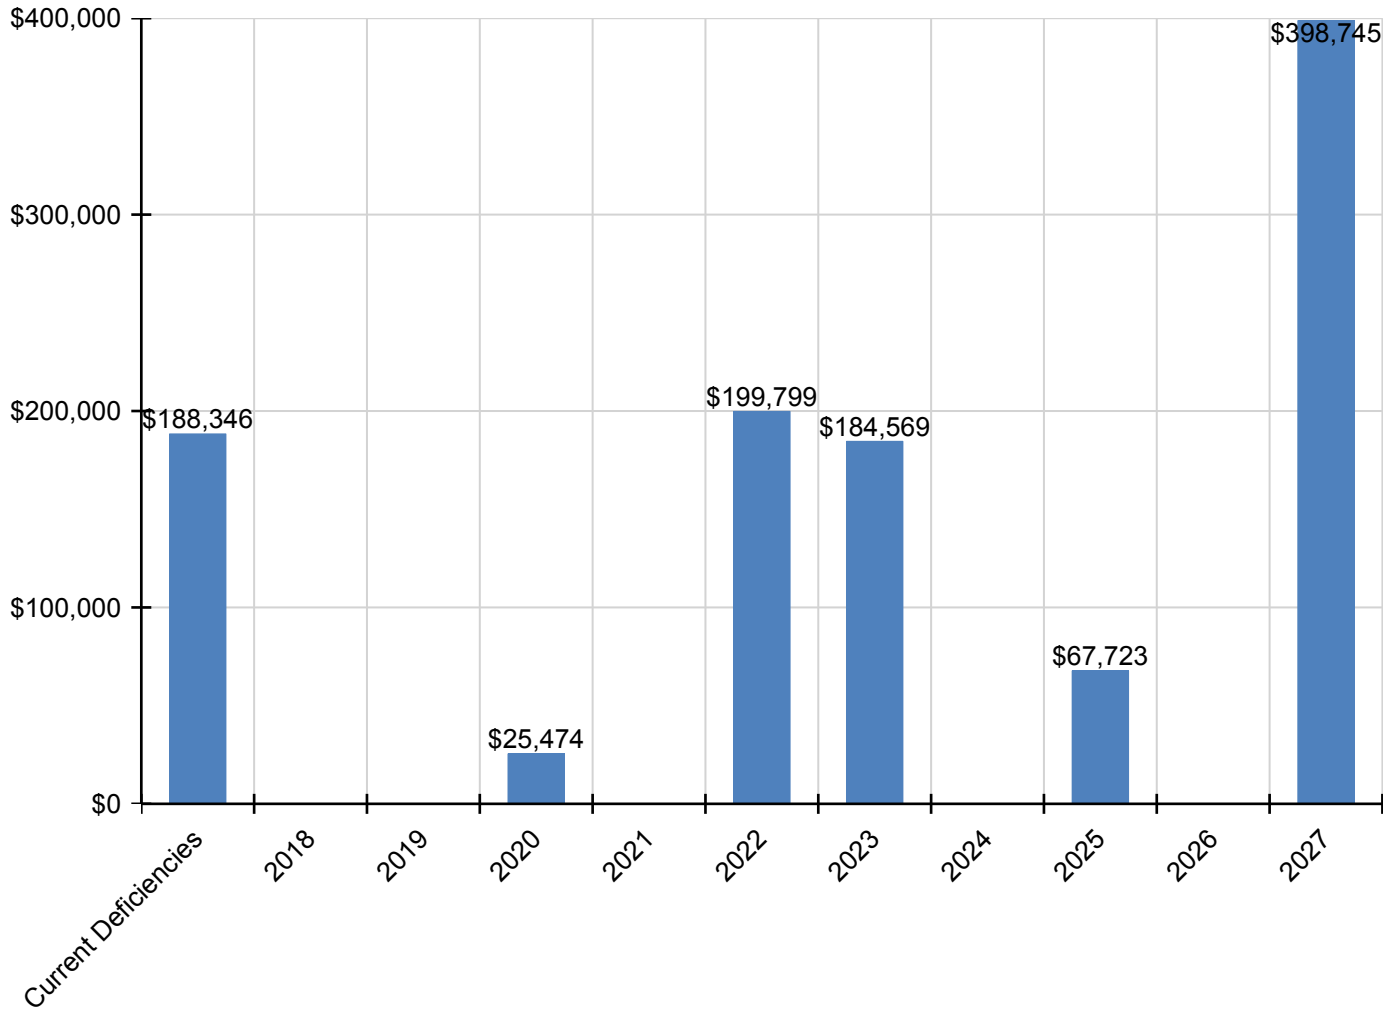
Forecasted Capital Renewal Requirement

The following chart shows the current building deficiencies and forecasting capital renewal or sustainment requirements over the next ten years.

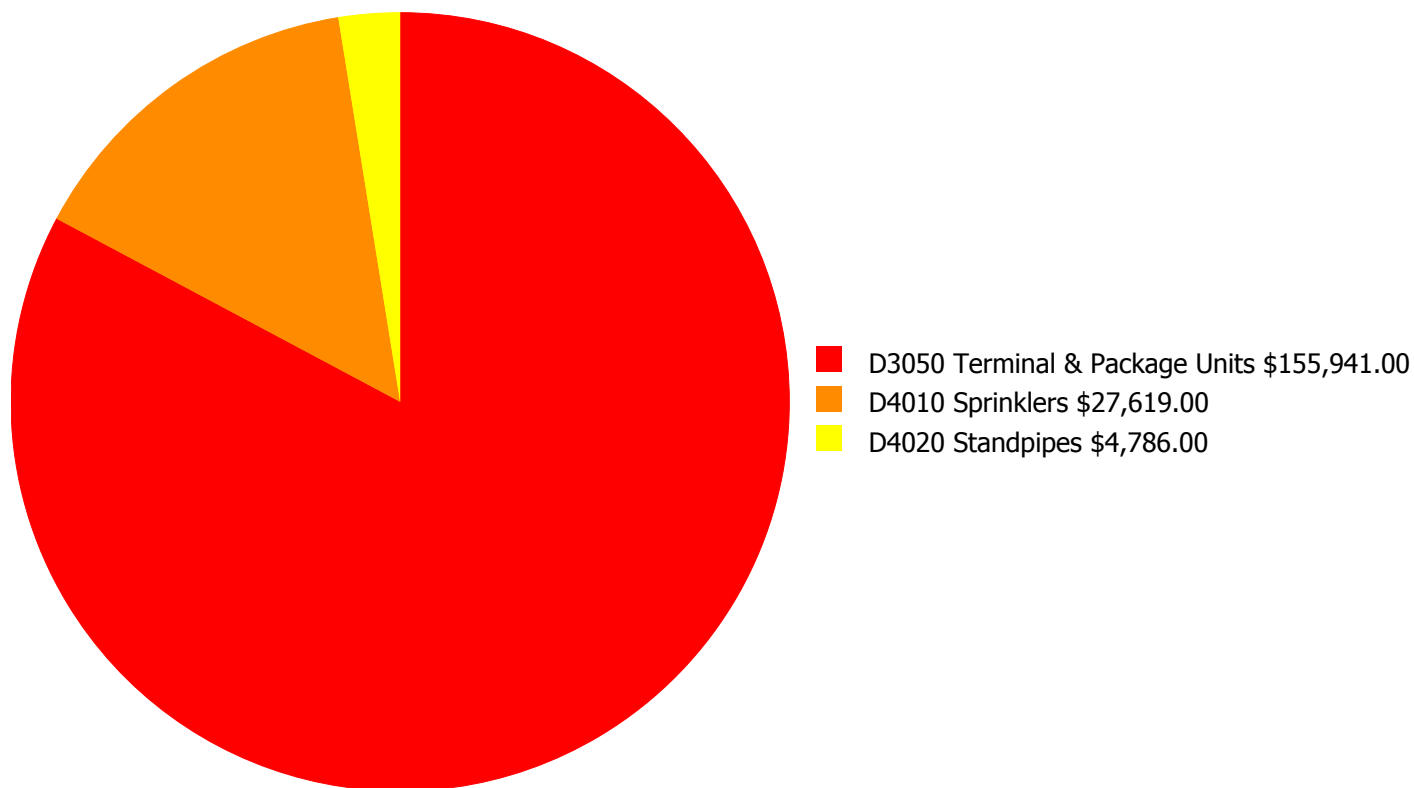
Deficiency Summary by System

Current deficiencies included assemblies that have reached or exceeded their design life or components of the assemblies that are in need of repair. Assemblies that have reached their design life are identified as current deficiencies and assigned the distress 'Beyond Useful Life'. The following chart lists all current deficiencies associated with this facility.

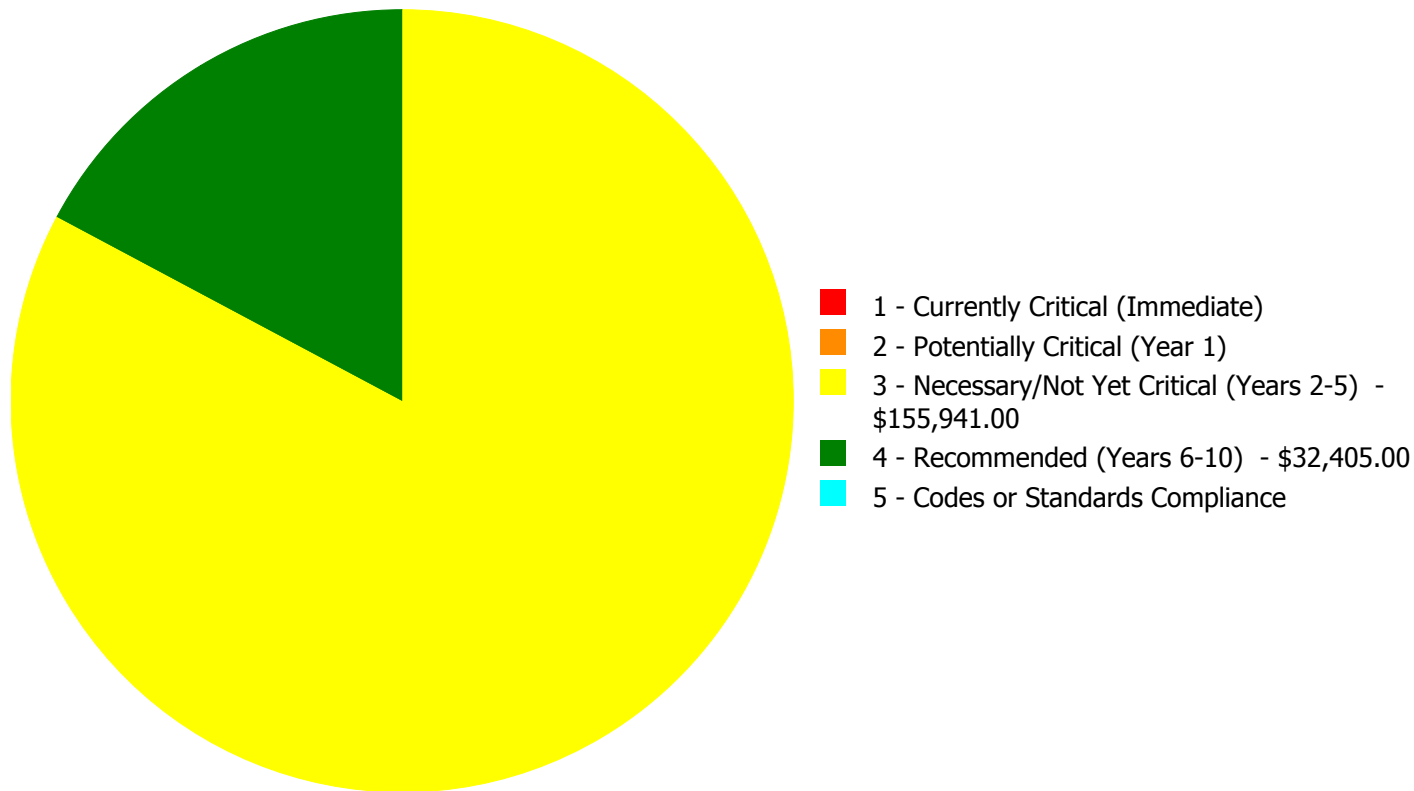
Deficiency Summary by Priority

The following chart shows the total repair costs broken down by priority. Assessors assigned deficiencies within eCOMET to one of the following priority categories:

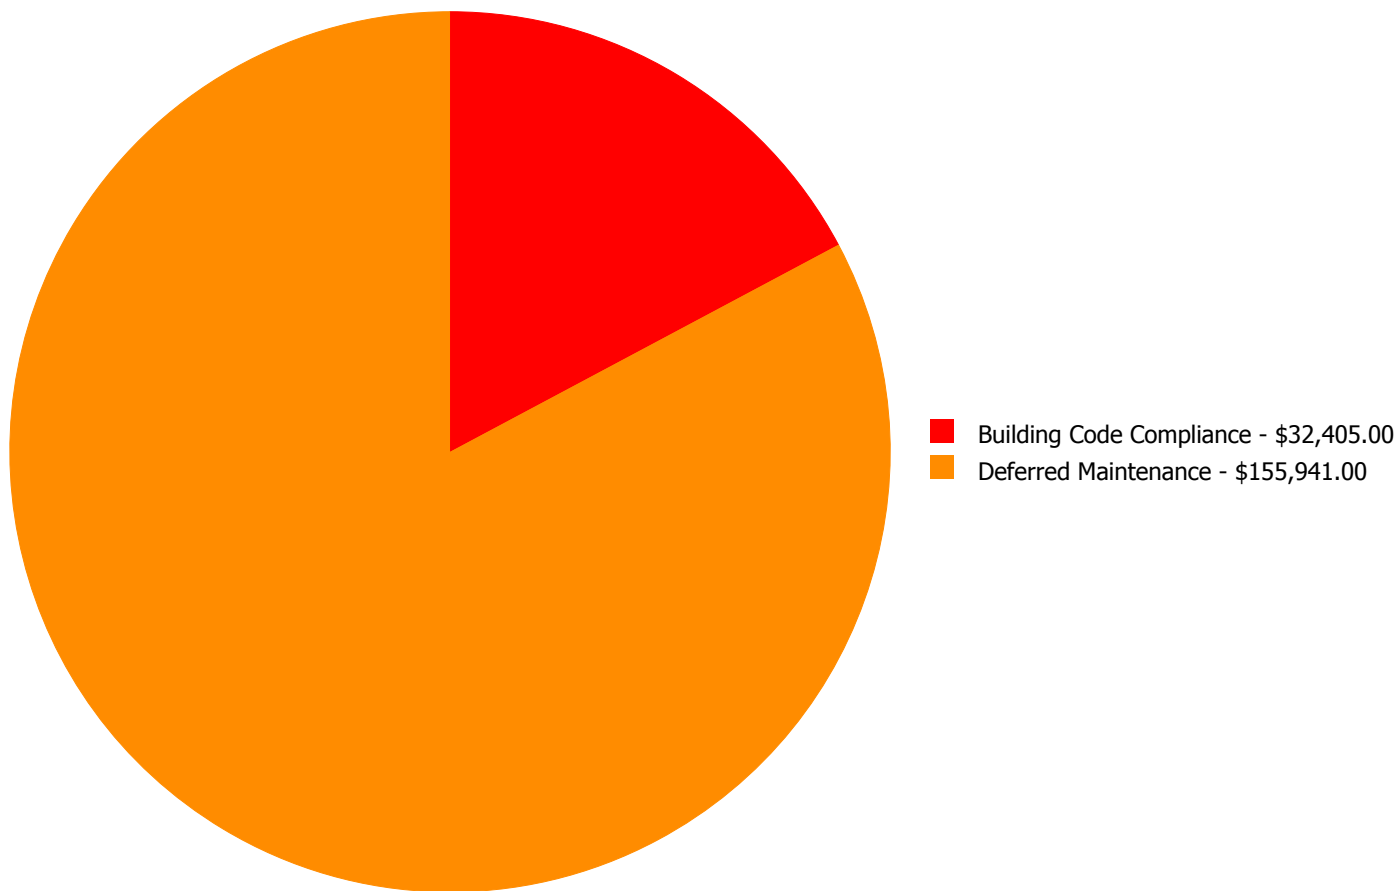
Deficiency Summary by Category

The following chart shows the total repair costs broken down by deficiency categories. Assessors assigned deficiencies to one of the following categories:

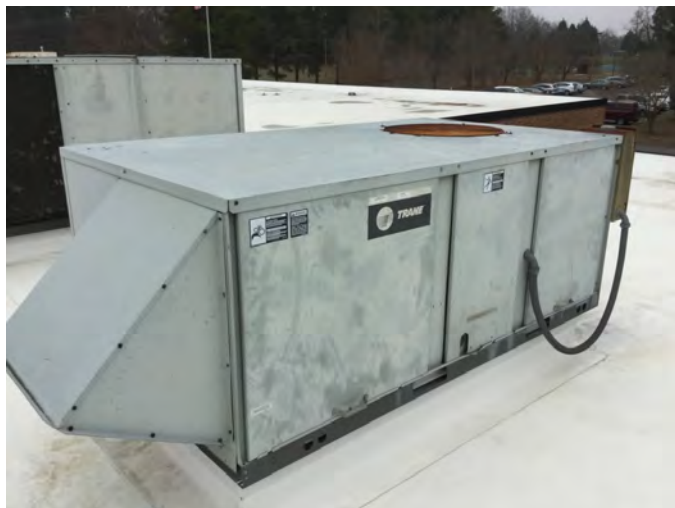
System: D3050 - Terminal & Package Units

Location: Roof
Distress: Beyond Service Life
Category: Deferred Maintenance
Priority: 3 - Necessary/Not Yet Critical (Years 2-5)
Correction: Renew System
Qty: 6,215.00
Unit of Measure: S.F.
Estimate: \$155,941.00
Assessor Name: Somnath Das
Date Created: 01/25/2017

Notes: The RTU serving the addition is original and beyond its expected useful life. System renewal is recommended.

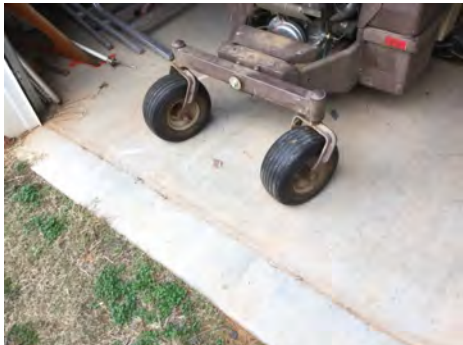
System: A1030 - Slab on Grade

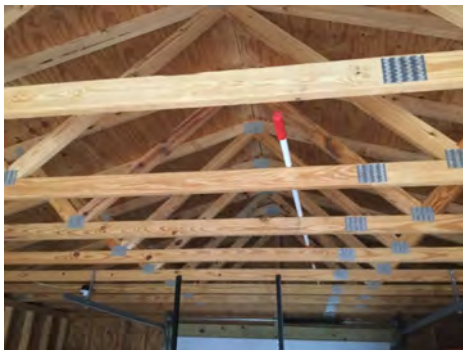
System: B1020 - Roof Construction

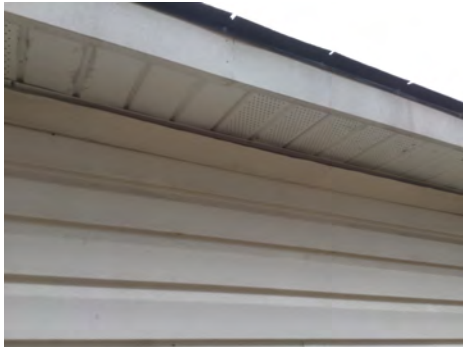
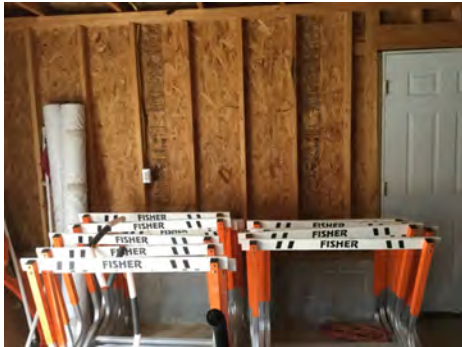
System: B2010 - Exterior Walls

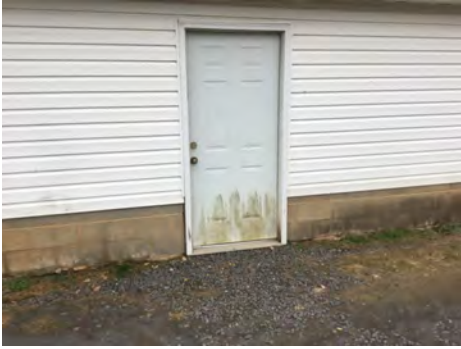
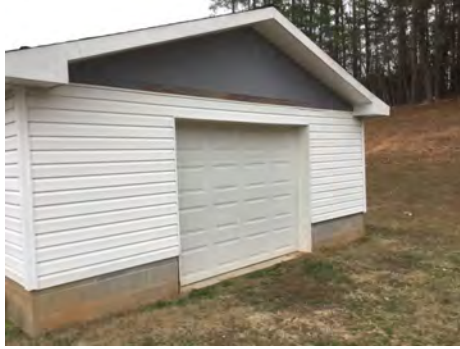
System: B2030 - Exterior Doors

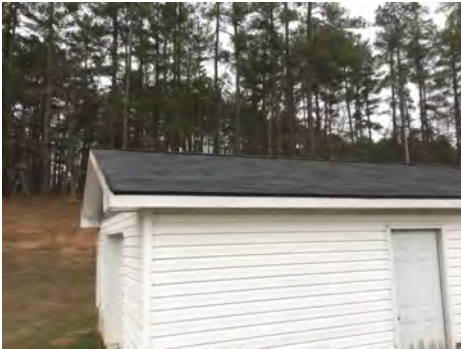
System: B3010140 - Asphalt Shingles

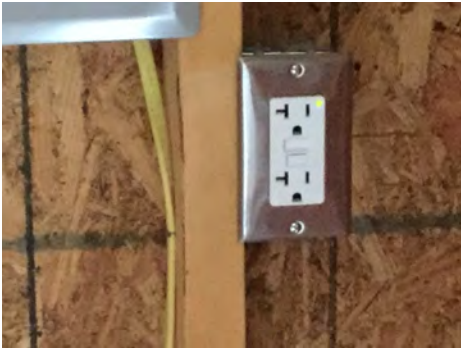
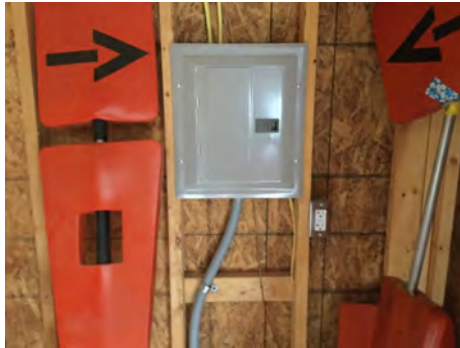
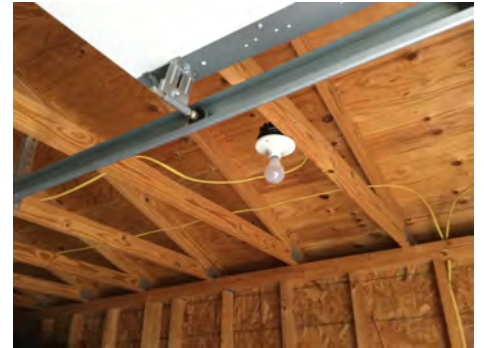
System: D5020 - Lighting and Branch Wiring

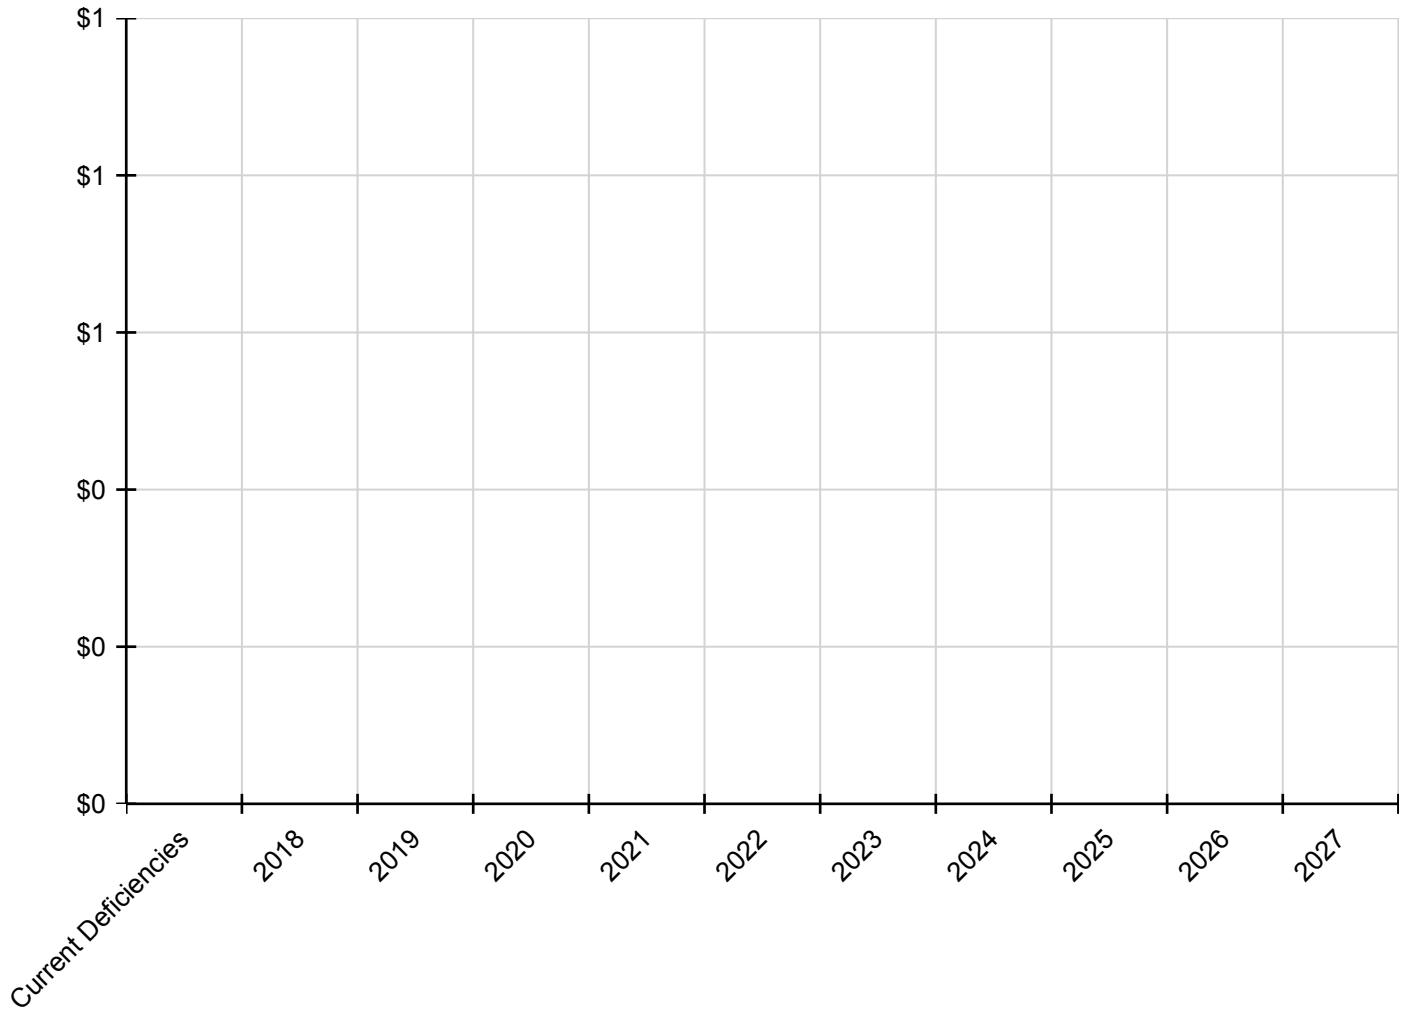
Forecasted Capital Renewal Requirement

The following chart shows the current building deficiencies and forecasting capital renewal or sustainment requirements over the next ten years.

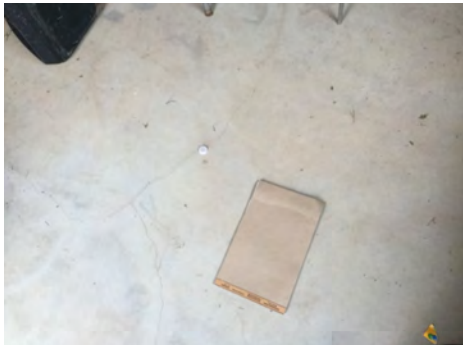
System: A1030 - Slab on Grade

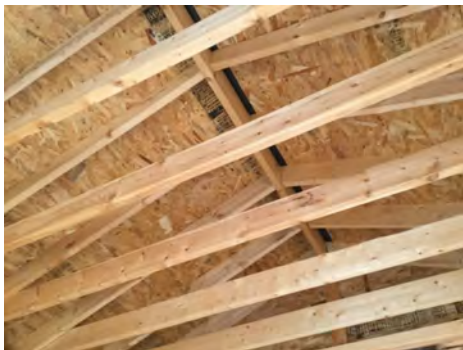
System: B1020 - Roof Construction

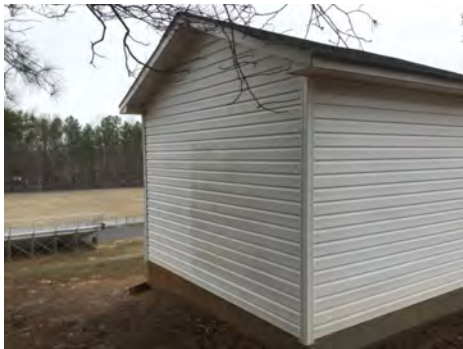
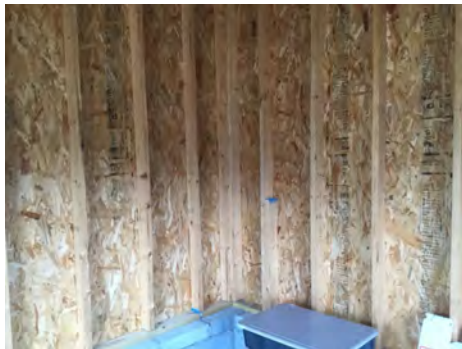
System: B2010 - Exterior Walls

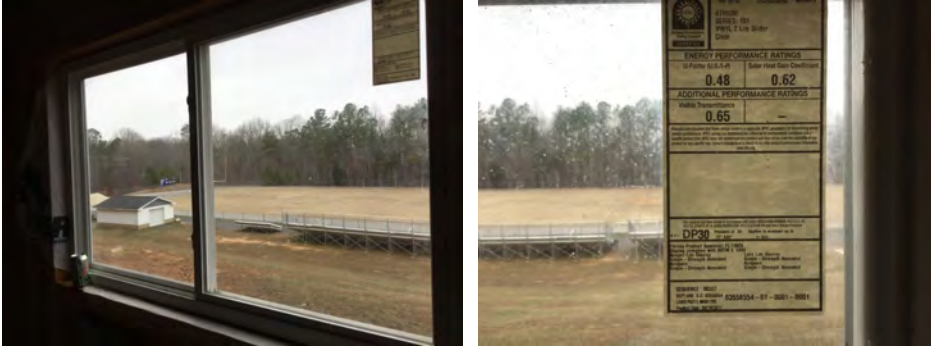
System: B2020 - Exterior Windows

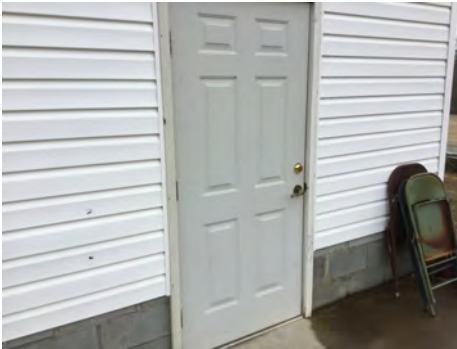
System: B2030 - Exterior Doors

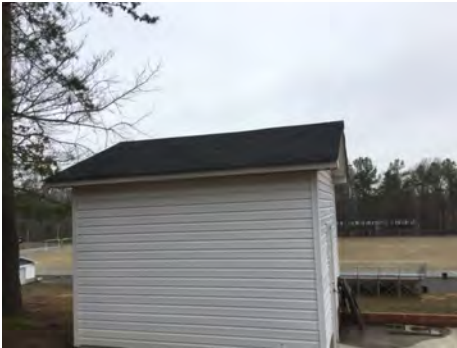
System: B3010140 - Asphalt Shingles

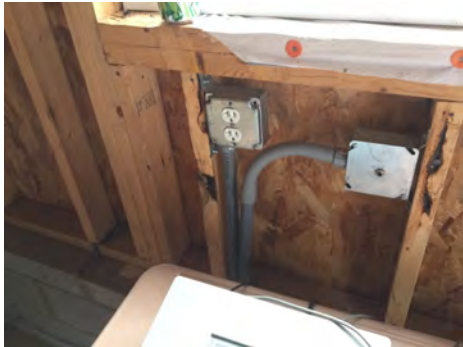
System: D5020 - Branch Wiring

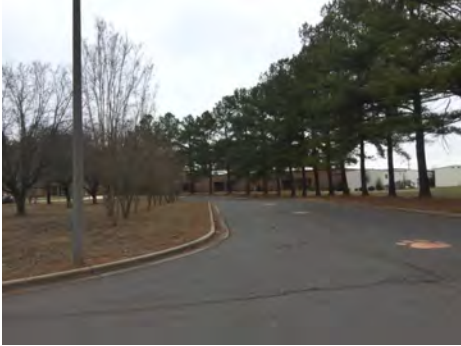
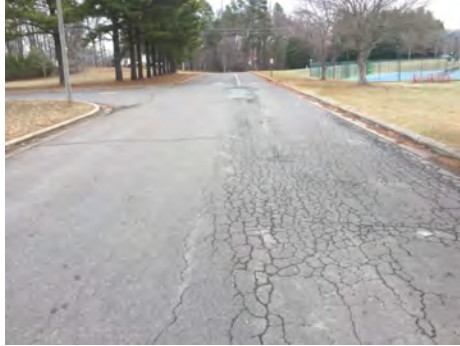
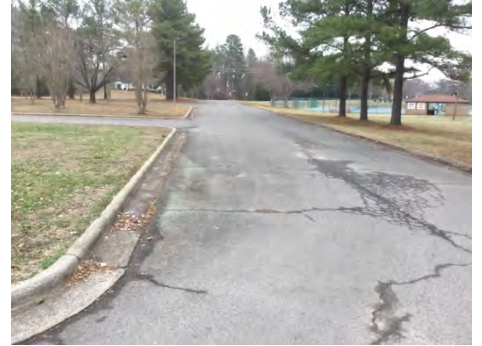
System: G2010 - Roadways

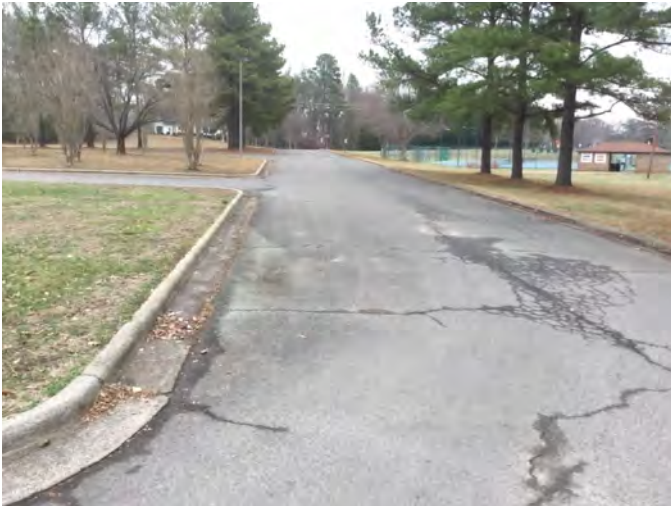
System: G2010 - Roadways

Location: Site
Distress: Beyond Service Life
Category: Deferred Maintenance
Priority: 3 - Necessary/Not Yet Critical (Years 2-5)
Correction: Renew System
Qty: 80,770.00
Unit of Measure: S.F.
Estimate: \$374,934.00
Assessor Name: Ann Buerger Linden
Date Created: 12/13/2016

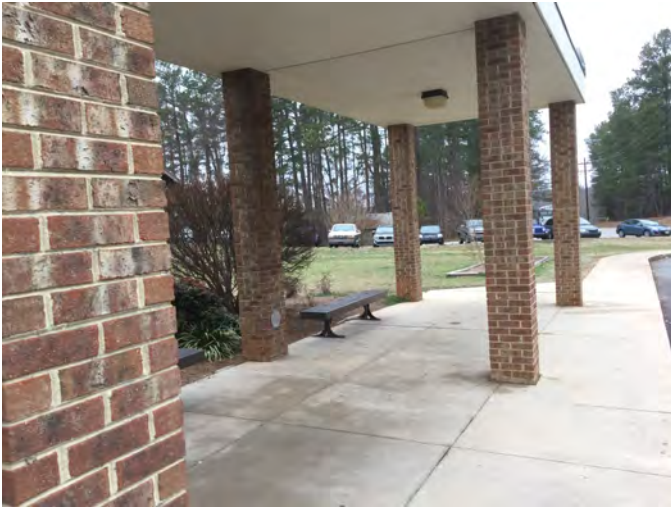
System: G2030 - Pedestrian Paving

Location: Site
Distress: Beyond Service Life
Category: Deferred Maintenance
Priority: 3 - Necessary/Not Yet Critical (Years 2-5)
Correction: Renew System
Qty: 80,770.00
Unit of Measure: S.F.
Estimate: \$175,917.00
Assessor Name: Ann Buerger Linden
Date Created: 12/13/2016

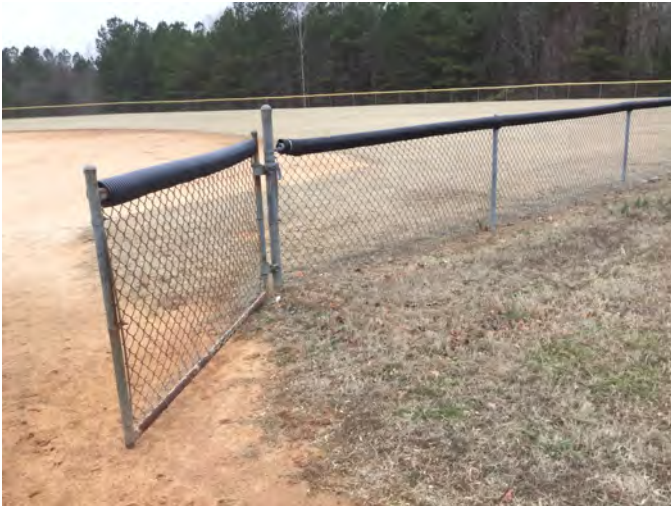
System: G2040105 - Fence & Guardrails

Location: Site
Distress: Beyond Service Life
Category: Deferred Maintenance
Priority: 3 - Necessary/Not Yet Critical (Years 2-5)
Correction: Renew System
Qty: 80,770.00
Unit of Measure: S.F.
Estimate: \$106,616.00
Assessor Name: Ann Buerger Linden
Date Created: 12/13/2016

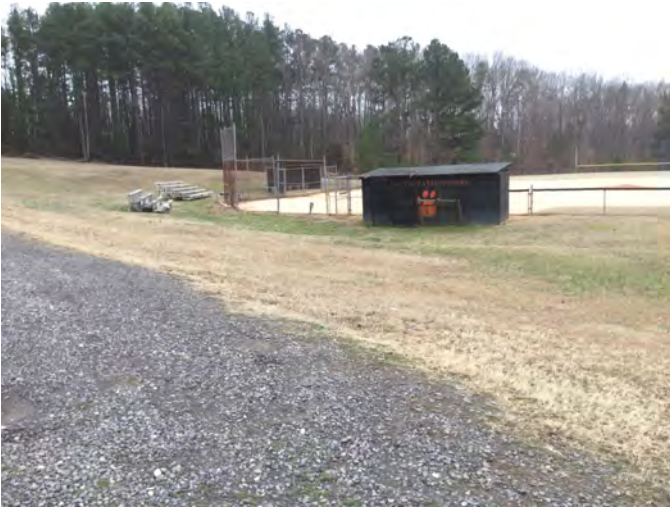
System: G2040950 - Baseball Field

Location: Site
Distress: Beyond Service Life
Category: Deferred Maintenance
Priority: 3 - Necessary/Not Yet Critical (Years 2-5)
Correction: Renew System
Qty: 80,770.00
Unit of Measure: S.F.
Estimate: \$629,037.00
Assessor Name: Ann Buerger Linden
Date Created: 12/13/2016

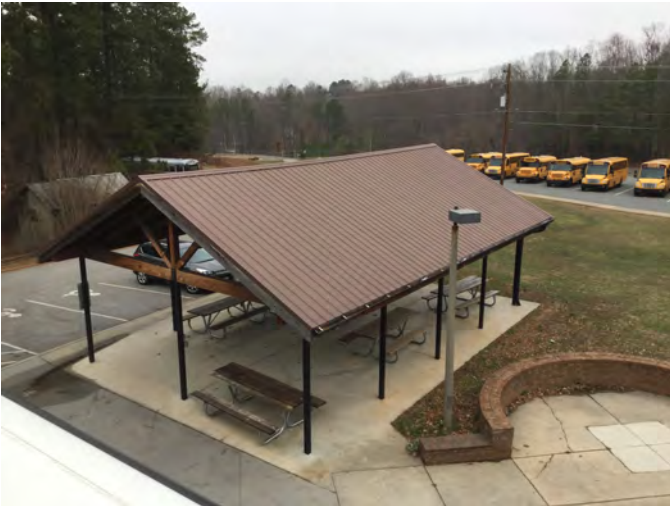
System: G2040950 - Canopies

Location: Site
Distress: Beyond Service Life
Category: Deferred Maintenance
Priority: 3 - Necessary/Not Yet Critical (Years 2-5)
Correction: Renew System
Qty: 80,770.00
Unit of Measure: S.F.
Estimate: \$21,323.00
Assessor Name: Ann Buerger Linden
Date Created: 12/13/2016

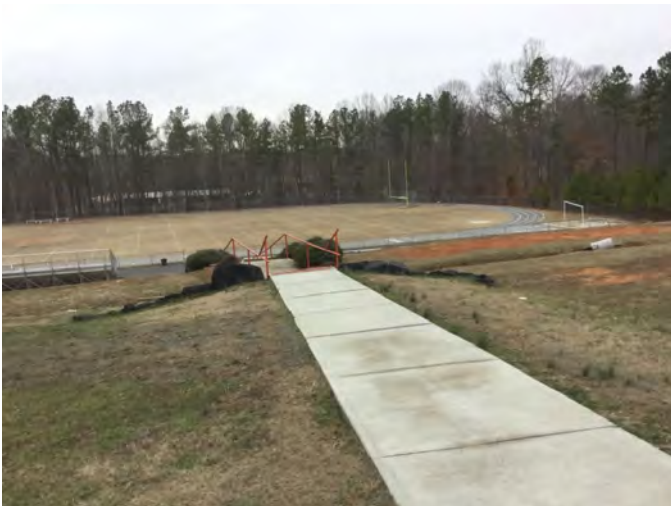
System: G2040950 - Football Field

Location: Site
Distress: Beyond Service Life
Category: Deferred Maintenance
Priority: 3 - Necessary/Not Yet Critical (Years 2-5)
Correction: Renew System
Qty: 80,770.00
Unit of Measure: S.F.
Estimate: \$420,246.00
Assessor Name: Ann Buerger Linden
Date Created: 12/13/2016

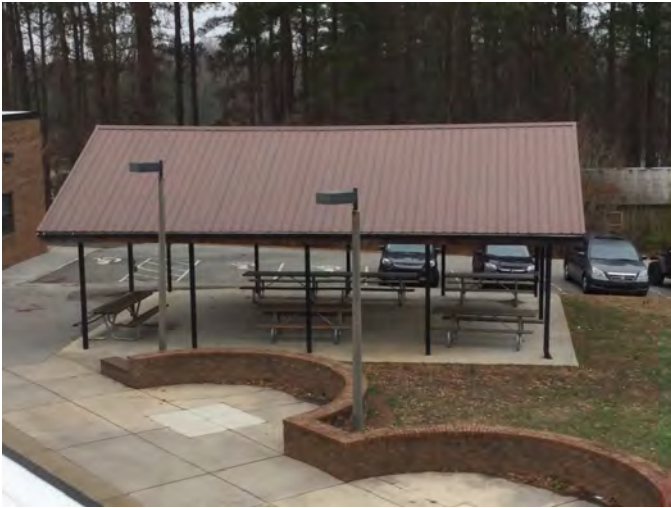
System: G4020 - Site Lighting

Location: Site
Distress: Beyond Service Life
Category: Deferred Maintenance
Priority: 3 - Necessary/Not Yet Critical (Years 2-5)
Correction: Renew System
Qty: 80,770.00
Unit of Measure: S.F.
Estimate: \$135,047.00
Assessor Name: Ann Buerger Linden
Date Created: 12/13/2016

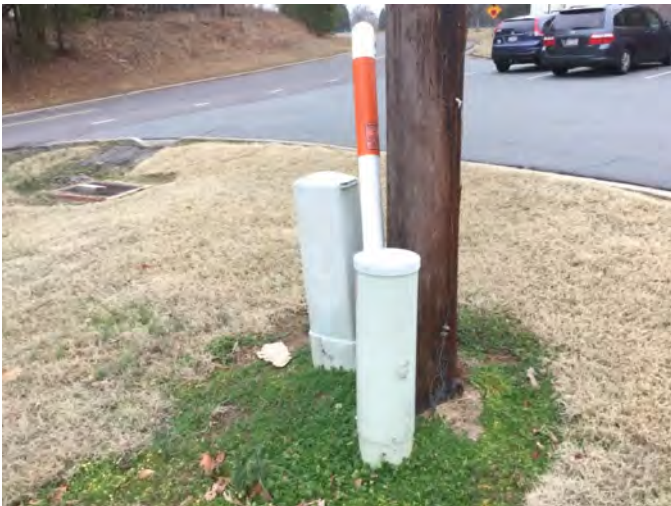
System: G4030 - Site Communications & Security

Location: Site
Distress: Beyond Service Life
Category: Deferred Maintenance
Priority: 3 - Necessary/Not Yet Critical (Years 2-5)
Correction: Renew System
Qty: 80,770.00
Unit of Measure: S.F.
Estimate: \$78,185.00
Assessor Name: Ann Buerger Linden
Date Created: 12/13/2016

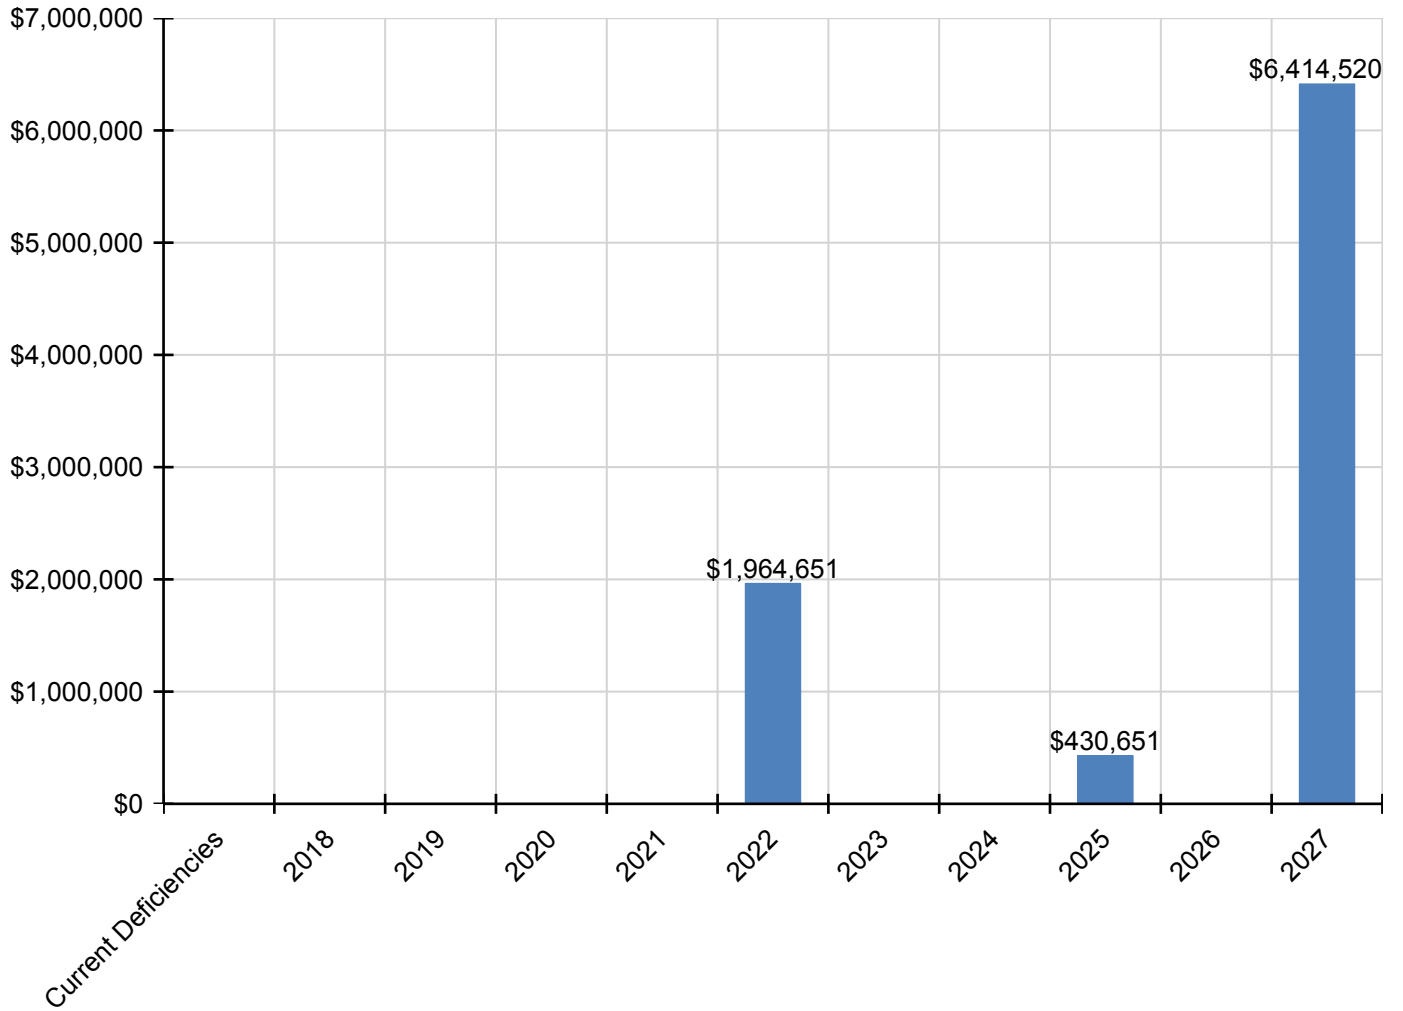
Forecasted Capital Renewal Requirement

The following chart shows the current building deficiencies and forecasting capital renewal or sustainment requirements over the next ten years.

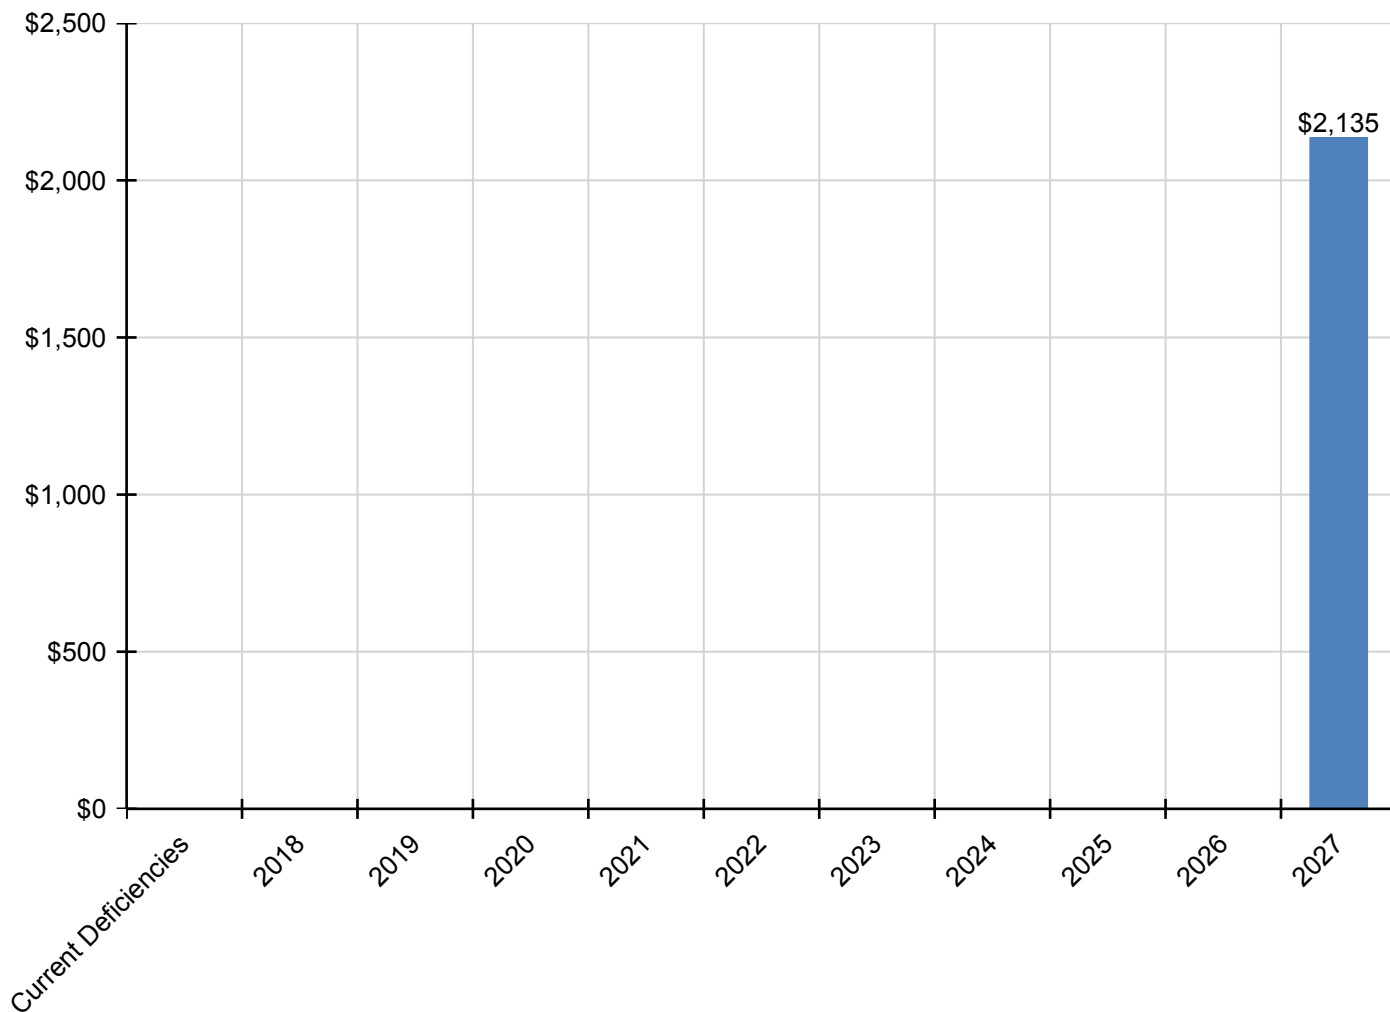
Forecasted Capital Renewal Requirement

The following chart shows the current building deficiencies and forecasting capital renewal or sustainment requirements over the next ten years.

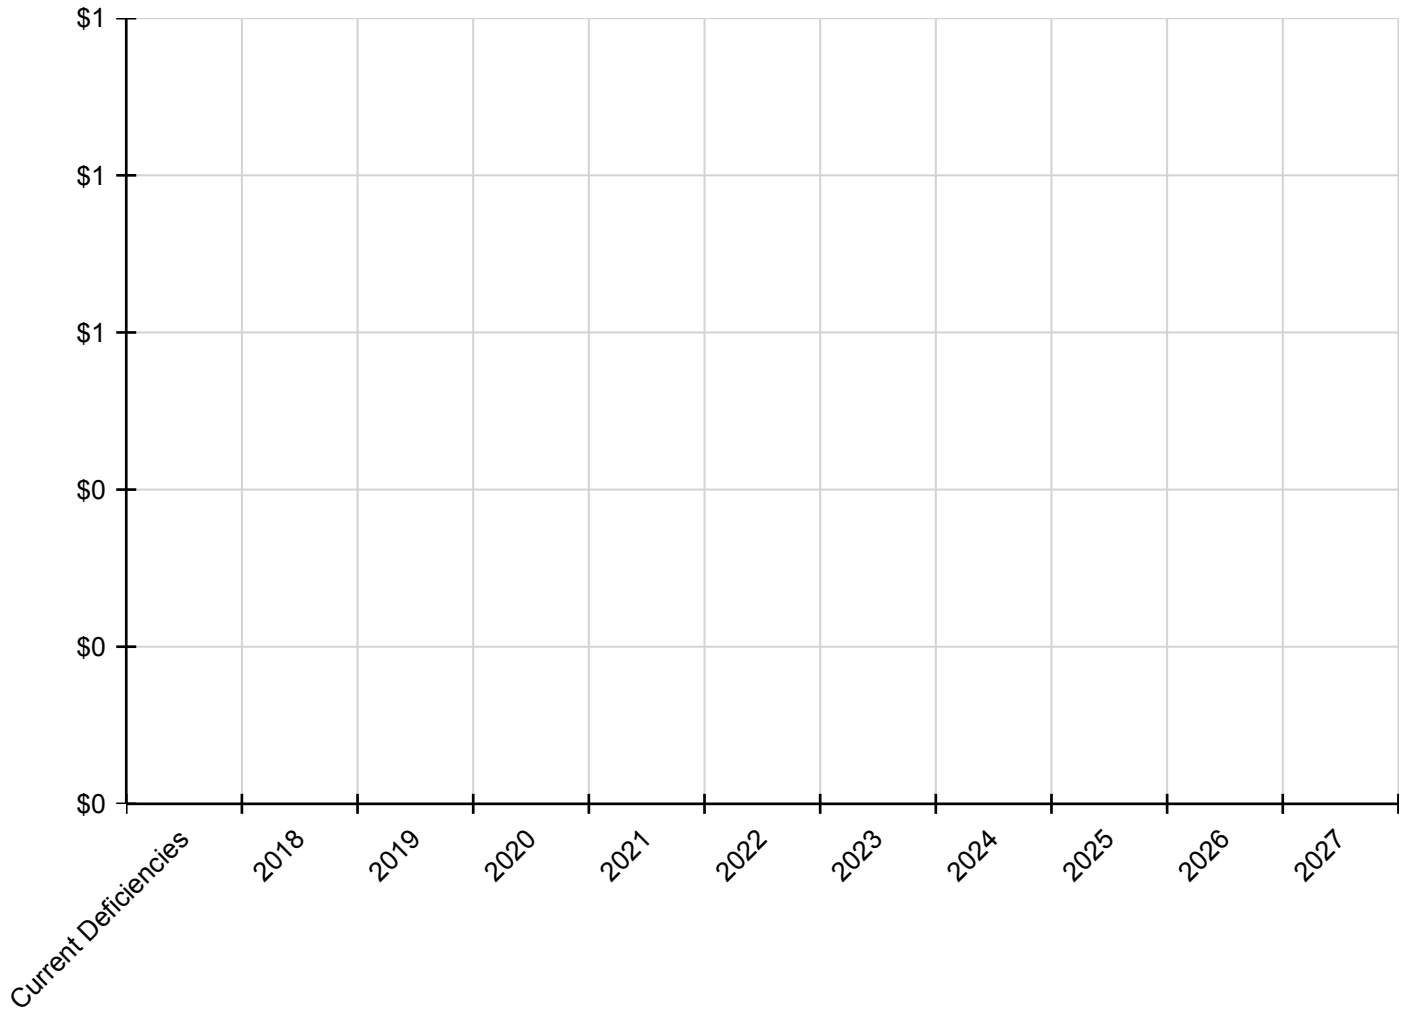
Forecasted Capital Renewal Requirement

The following chart shows the current building deficiencies and forecasting capital renewal or sustainment requirements over the next ten years.

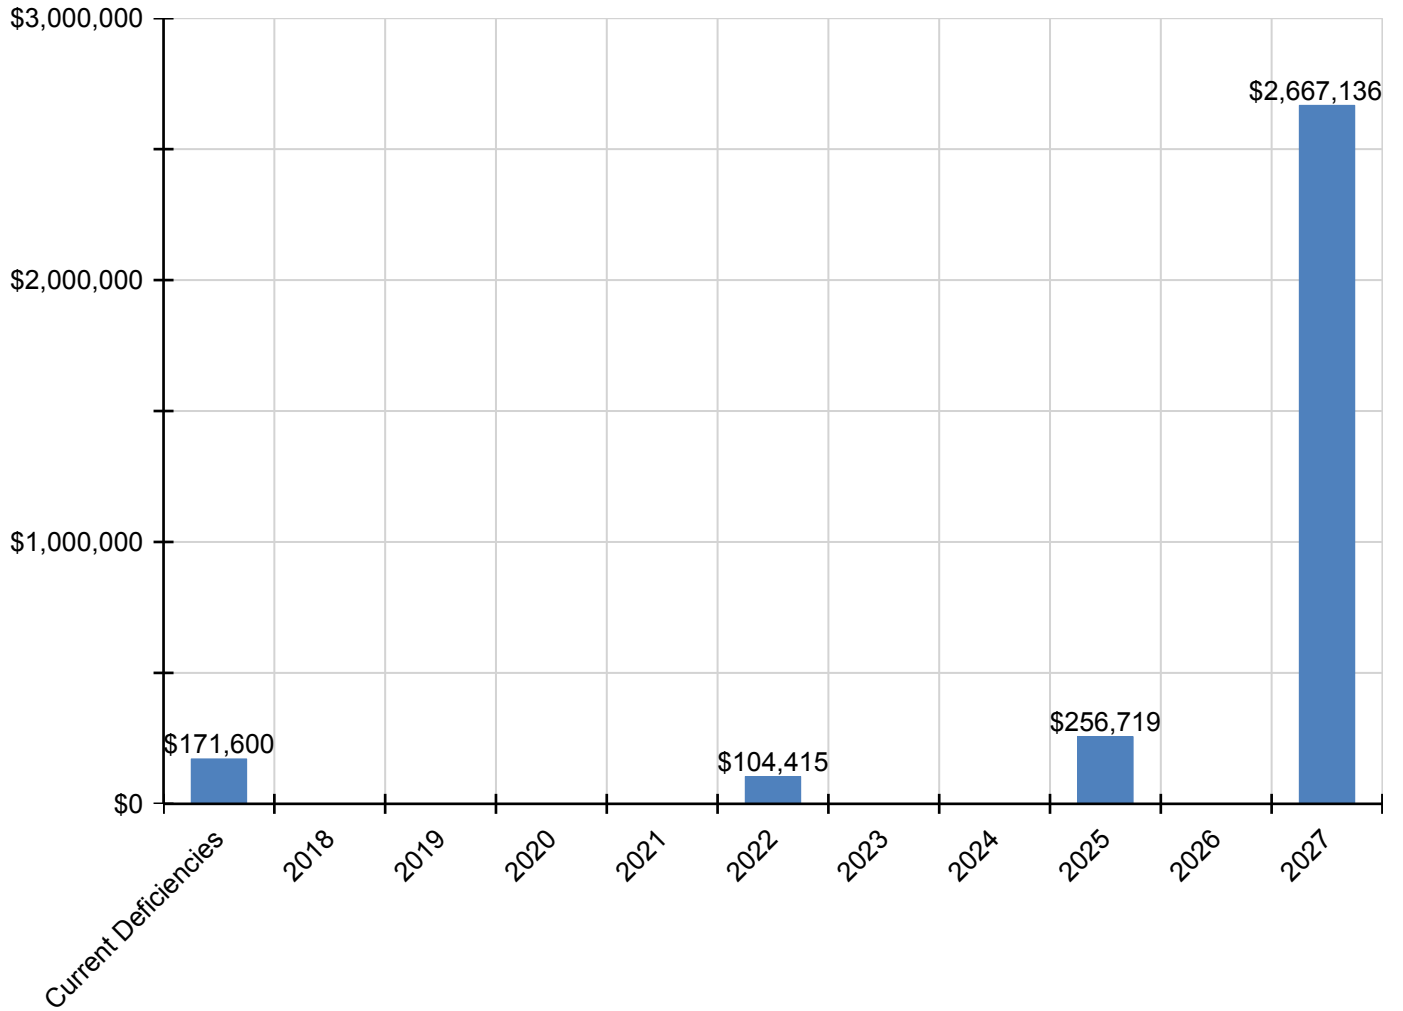
Forecasted Capital Renewal Requirement

The following chart shows the current building deficiencies and forecasting capital renewal or sustainment requirements over the next ten years.

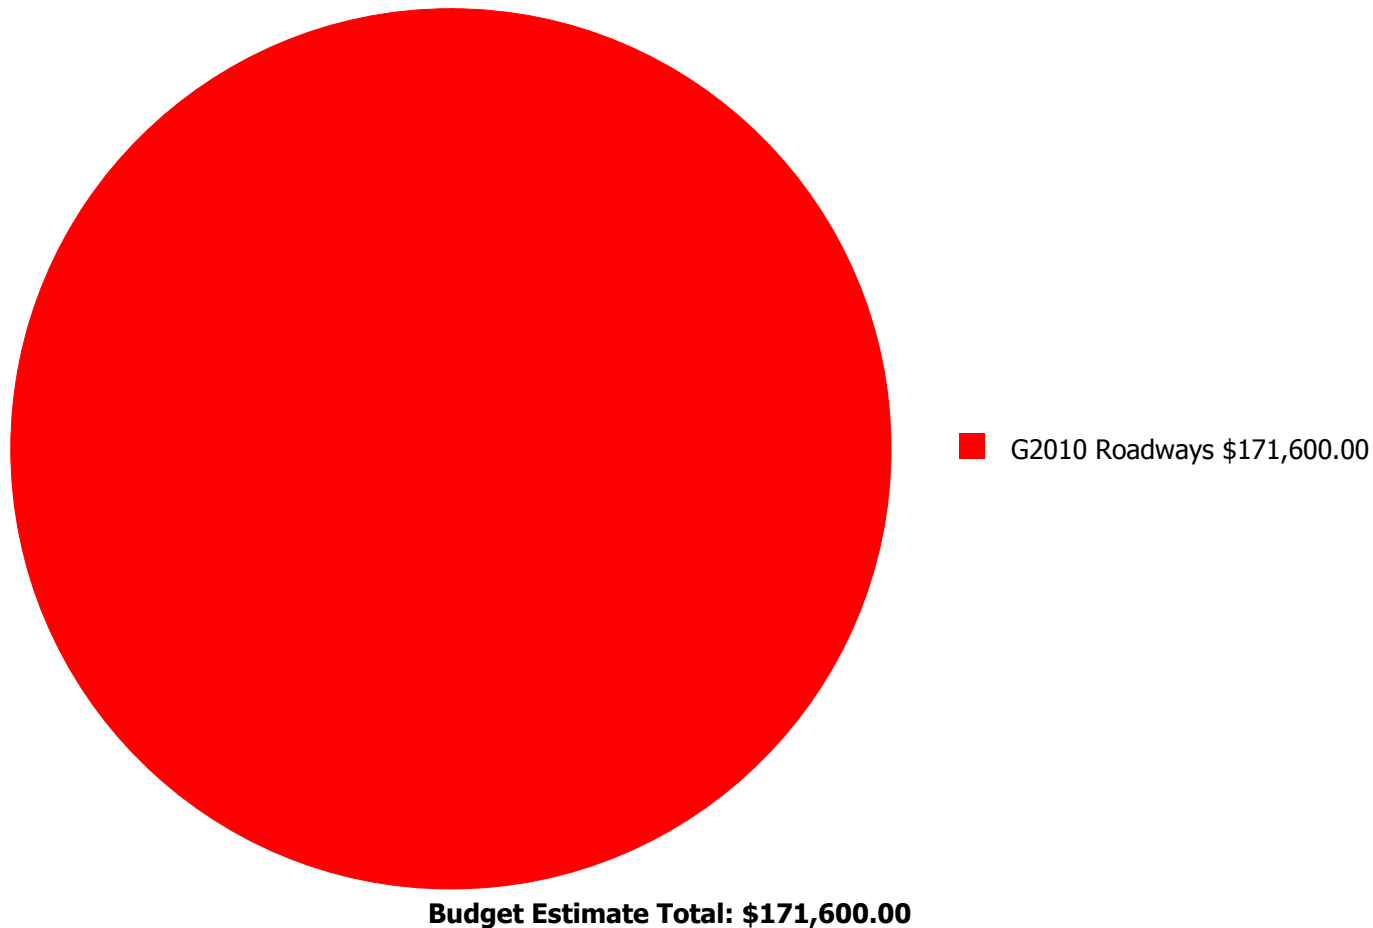
Deficiency Summary by System

Current deficiencies included assemblies that have reached or exceeded their design life or components of the assemblies that are in need of repair. Assemblies that have reached their design life are identified as current deficiencies and assigned the distress 'Beyond Useful Life'. The following chart lists all current deficiencies associated with this facility.

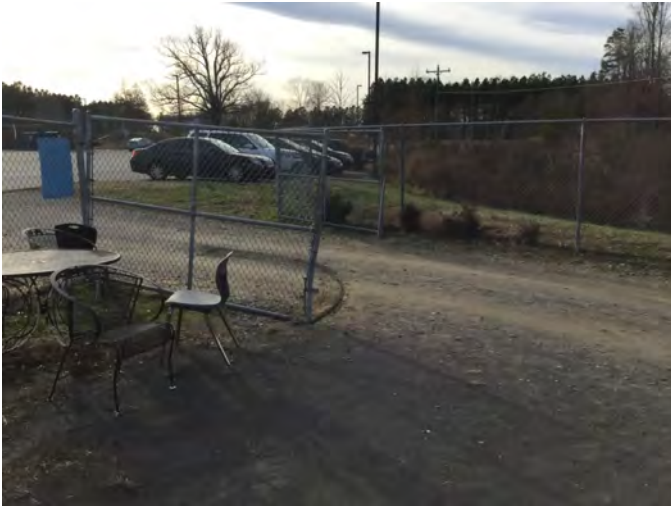
System: G2010 - Roadways

Location: Bus lot to athletic fields
Distress: Missing
Category: Deferred Maintenance / Safety
Priority: 4 - Recommended (Years 6-10)
Correction: Resurface the roadway
Qty: 1,000.00
Unit of Measure: L.F.
Estimate: \$171,600.00
Assessor Name: Terence Davis
Date Created: 02/11/2017

Notes: The road to the athletic fields is gravel. The circulation road east of the building is gravel. Paving with asphalt is recommended for safety and appearance..

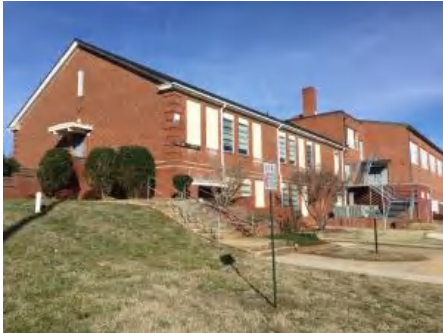
1). Southeast Elevation - Feb 09, 2017

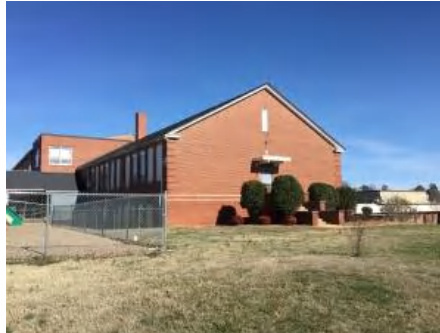
2). Southwest Elevation - Feb 09, 2017

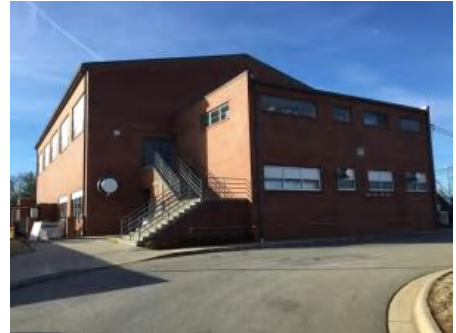
3). Northeast Elevation - Feb 09, 2017

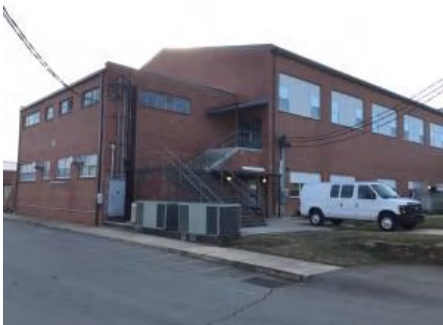
4). Northwest Elevation - Feb 09, 2017
