NC School District/300 Davie County/High School

Central Davie Academy

Campus Assessment Report

March 7, 2017

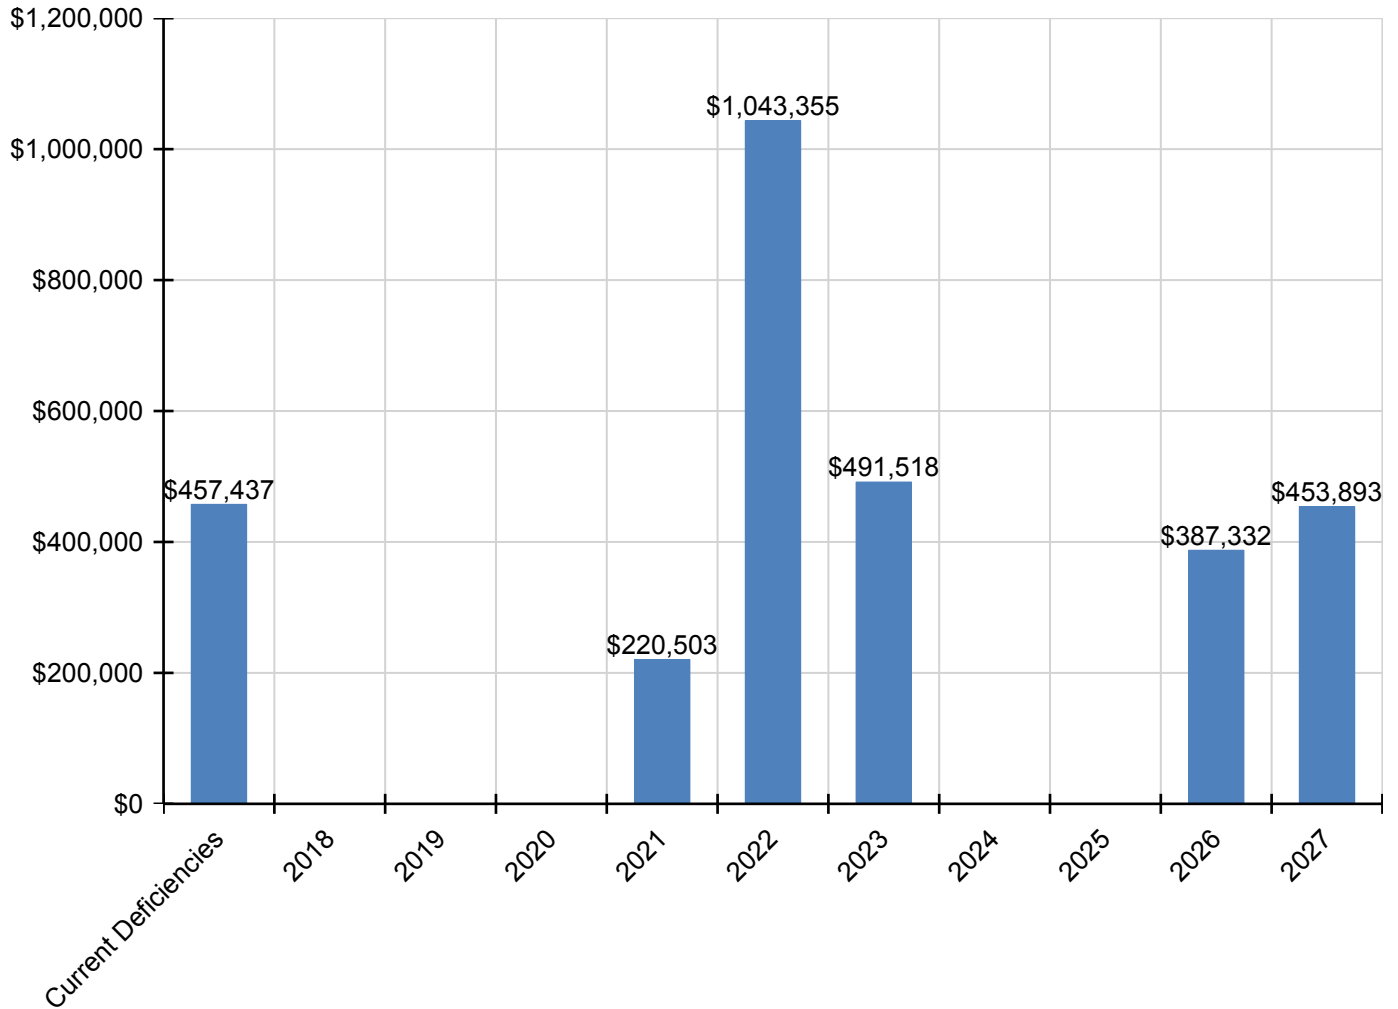
Forecasted Capital Renewal Requirement

The following chart shows the current building deficiencies and forecasting capital renewal or sustainment requirements over the next ten years.

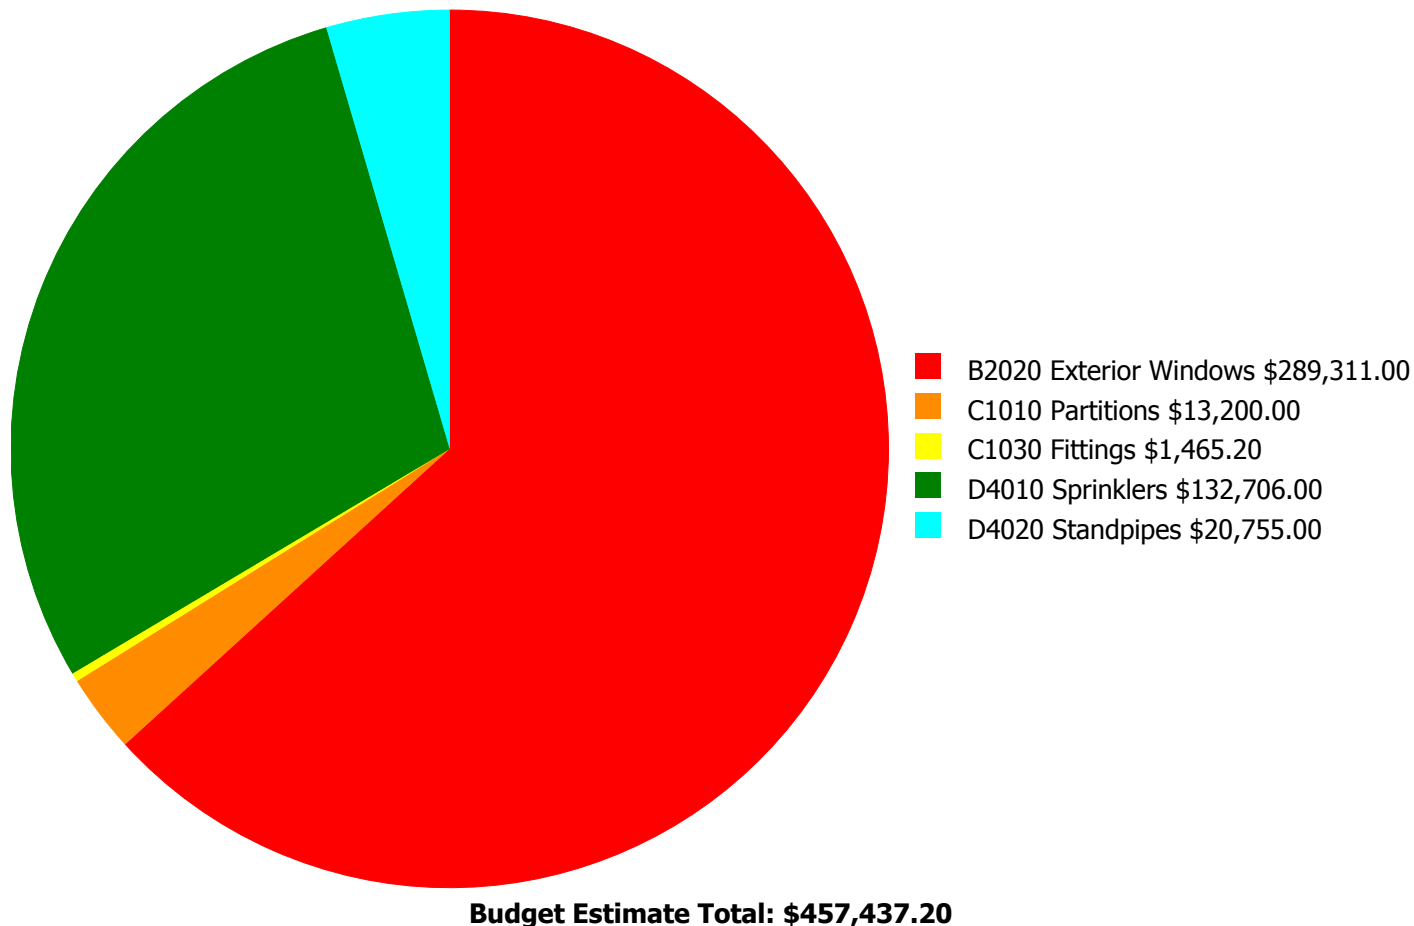
Deficiency Summary by System

Current deficiencies included assemblies that have reached or exceeded their design life or components of the assemblies that are in need of repair. Assemblies that have reached their design life are identified as current deficiencies and assigned the distress 'Beyond Useful Life'. The following chart lists all current deficiencies associated with this facility.

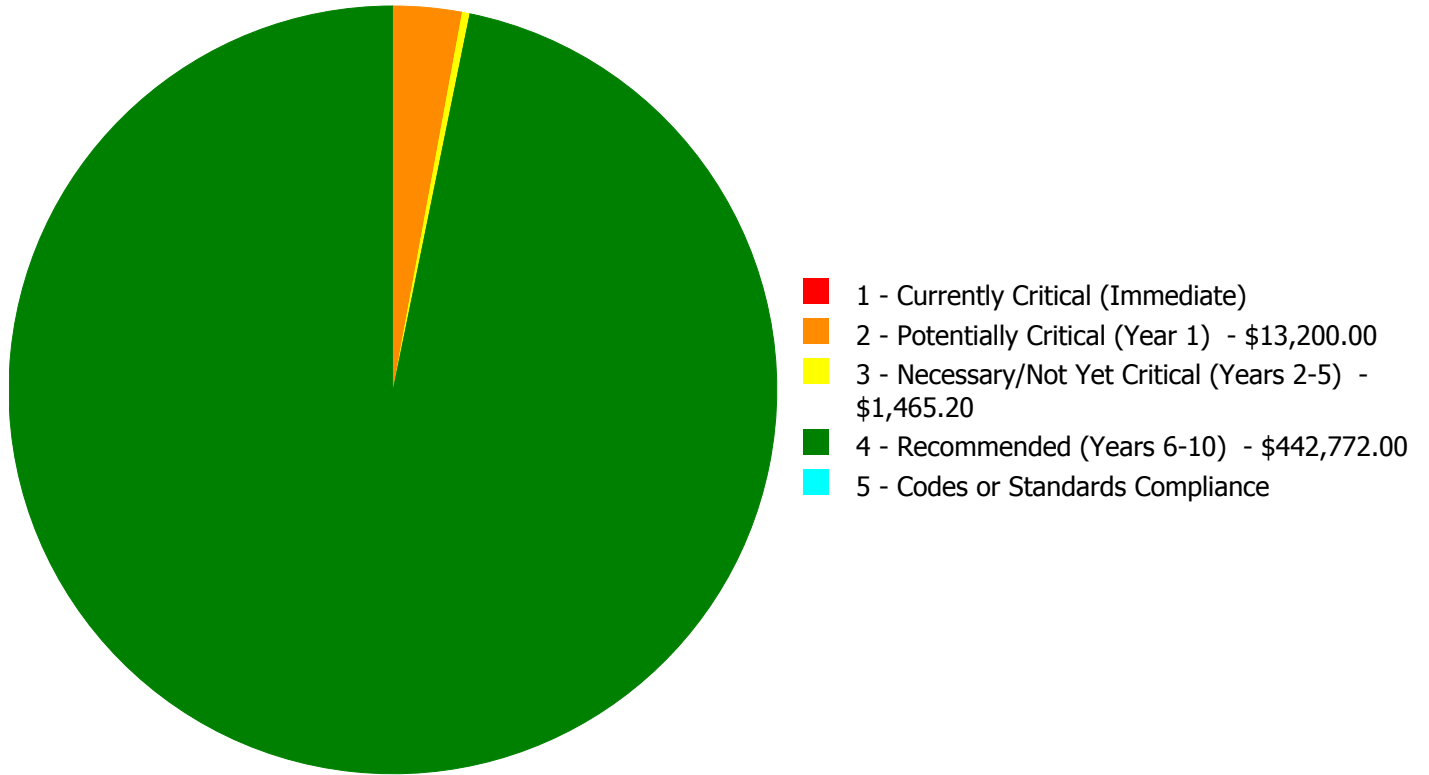
Deficiency Summary by Priority

The following chart shows the total repair costs broken down by priority. Assessors assigned deficiencies within eCOMET to one of the following priority categories:

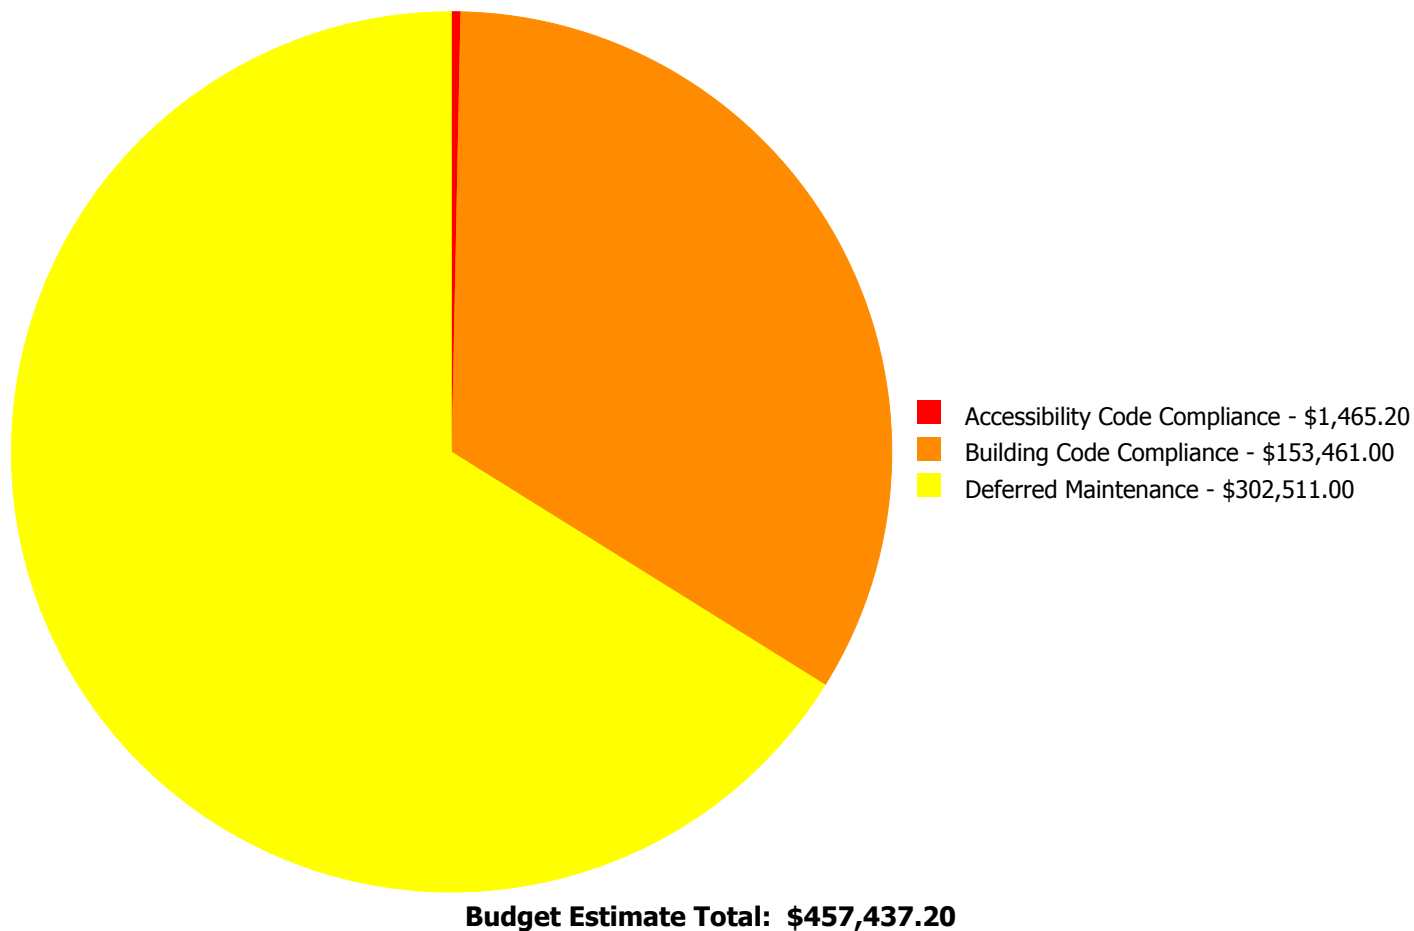
Deficiency Summary by Category

The following chart shows the total repair costs broken down by deficiency categories. Assessors assigned deficiencies to one of the following categories:

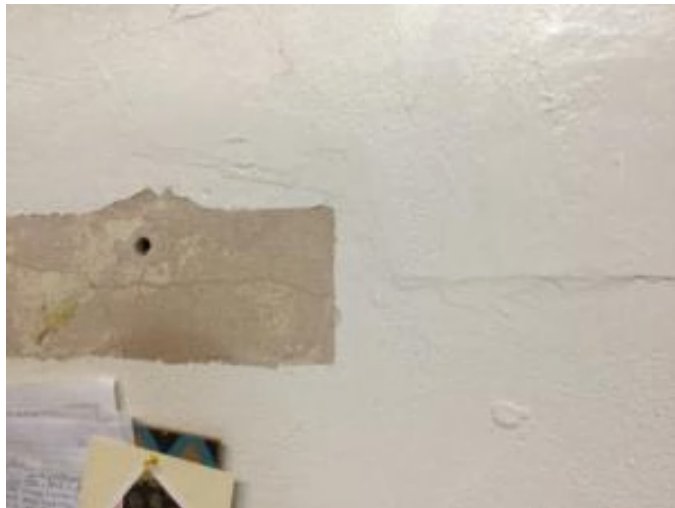
Location: South Interior Wall
Distress: Inadequate
Category: Deferred Maintenance
Priority: 2 - Potentially Critical (Year 1)
Correction: Engineering Study
Qty: 1.00
Unit of Measure: Ea.
Estimate: \$13,200.00
Assessor Name: Somnath Das
Date Created: 02/15/2017

Notes: There is a moisture related issue on the South interior wall.

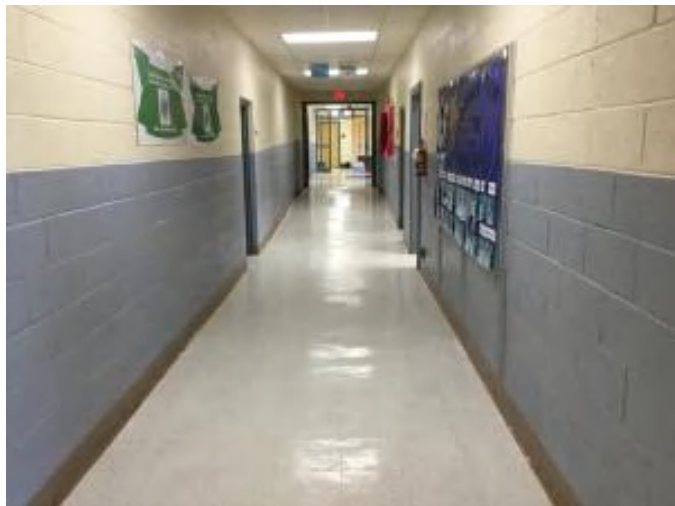
Location: Throughout the building
Distress: Inadequate
Category: Accessibility Code Compliance
Priority: 3 - Necessary/Not Yet Critical (Years 2-5)
Correction: Replace signage and toilet partitions
Qty: 30.00
Unit of Measure: Ea.
Estimate: \$1,465.20
Assessor Name: Somnath Das
Date Created: 02/15/2017

Notes: Signage is missing in several areas throughout the building.

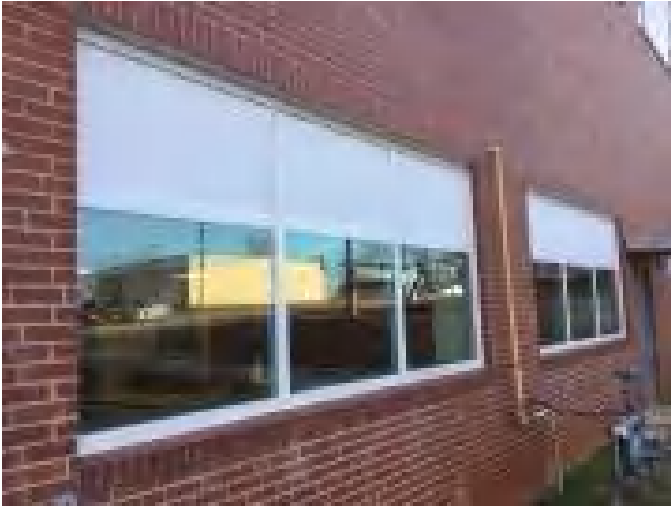
Location: Exterior
Distress: Inadequate
Category: Deferred Maintenance
Priority: 4 - Recommended (Years 6-10)
Correction: Renew System
Qty: 28,588.00
Unit of Measure: S.F.
Estimate: \$289,311.00
Assessor Name: Somnath Das
Date Created: 02/09/2017

Notes: The original metal frame, single pane, windows are aged, worn, inefficient and should be replaced.

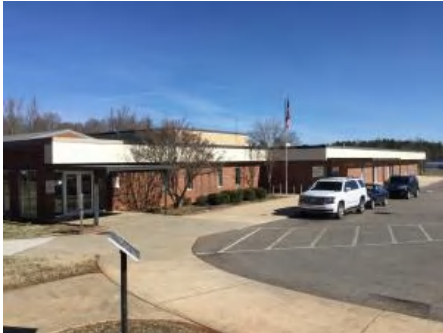
1). South Elevation - Feb 09, 2017

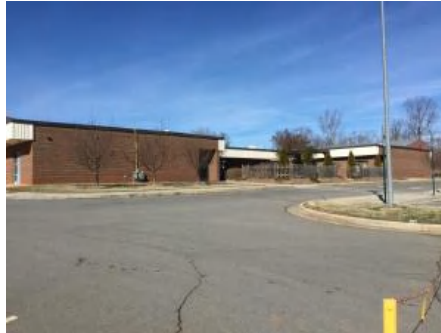
2). East Elevation - Feb 09, 2017

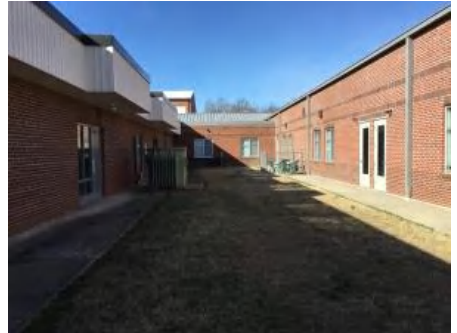
3). North Elevation - Feb 09, 2017

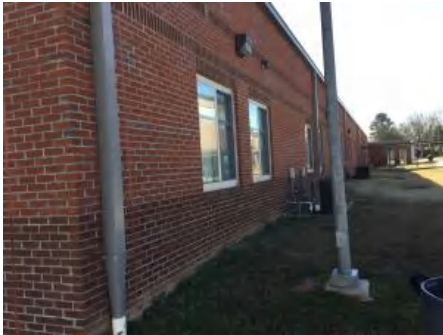
4). West Elevation - Feb 09, 2017

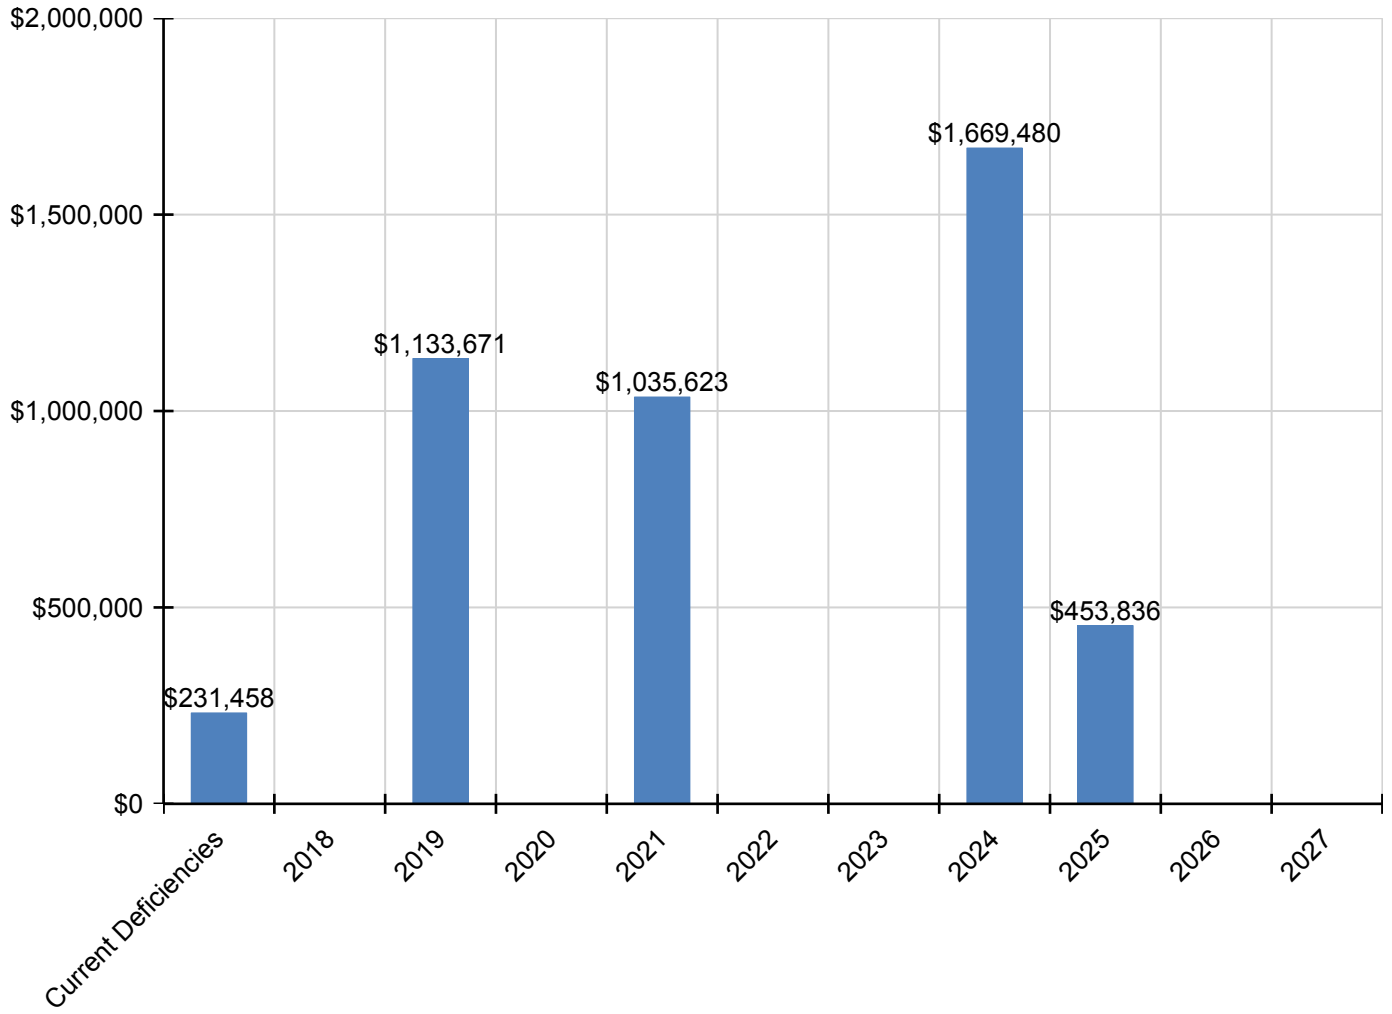
Forecasted Capital Renewal Requirement

The following chart shows the current building deficiencies and forecasting capital renewal or sustainment requirements over the next ten years.

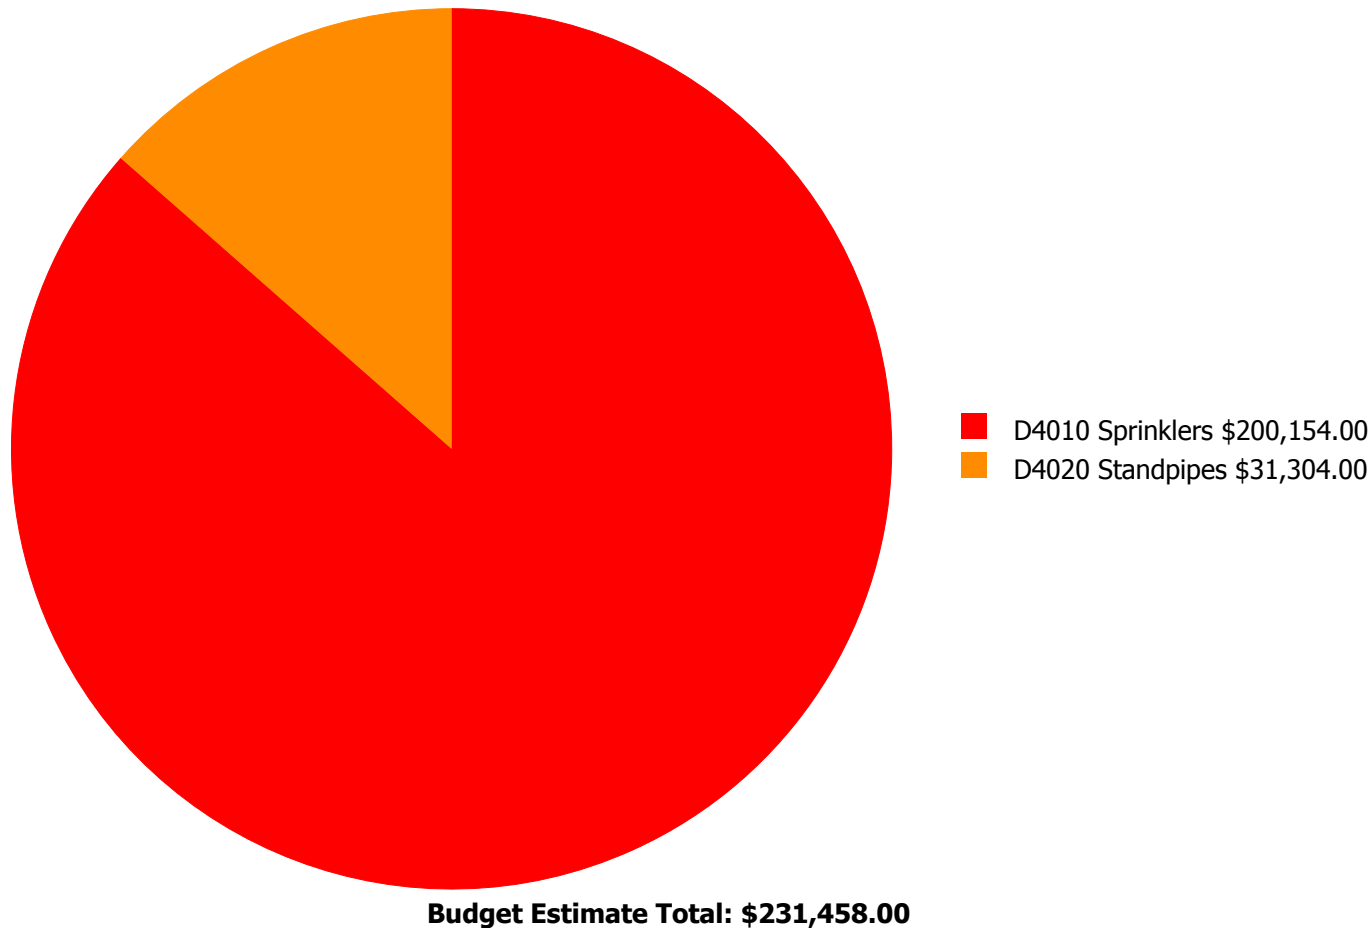
Deficiency Summary by System

Current deficiencies included assemblies that have reached or exceeded their design life or components of the assemblies that are in need of repair. Assemblies that have reached their design life are identified as current deficiencies and assigned the distress 'Beyond Useful Life'. The following chart lists all current deficiencies associated with this facility.

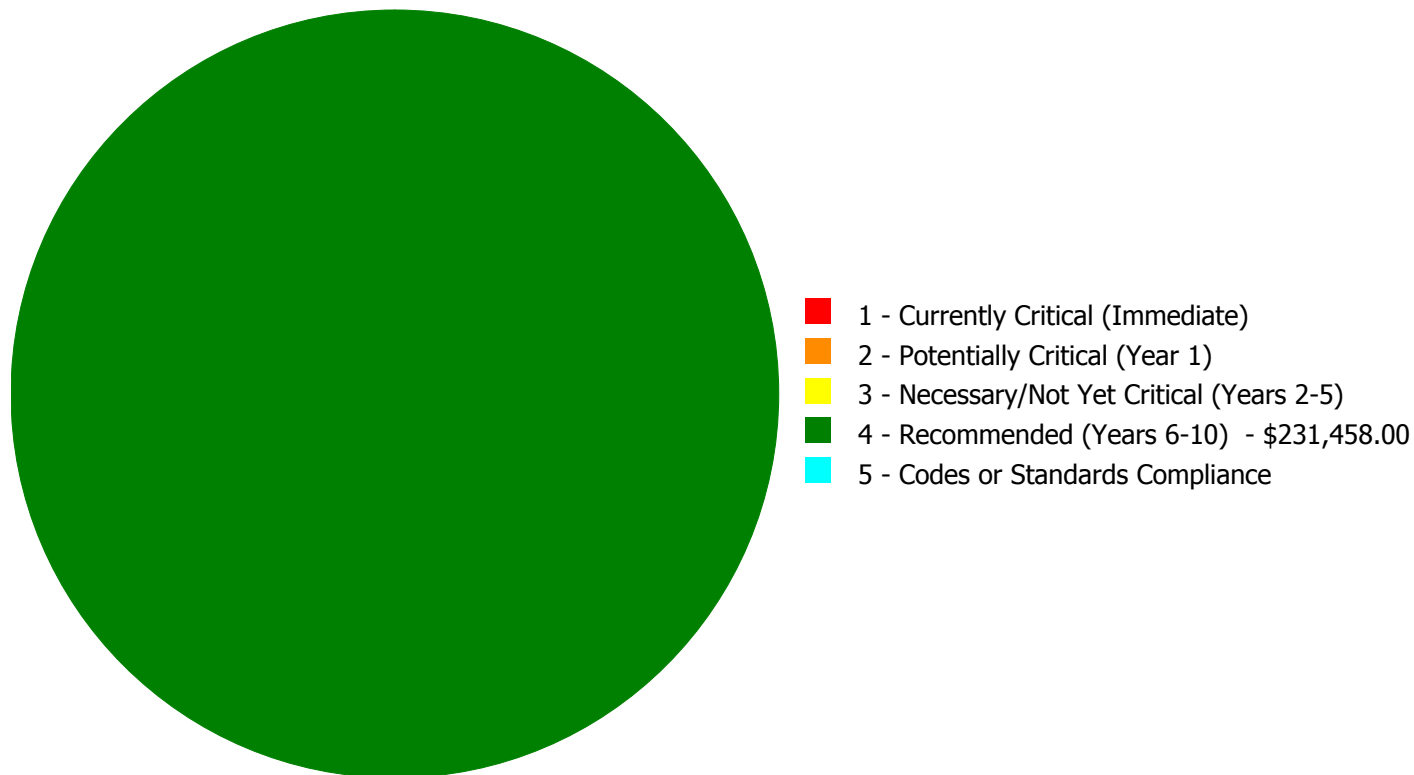
Deficiency Summary by Priority

The following chart shows the total repair costs broken down by priority. Assessors assigned deficiencies within eCOMET to one of the following priority categories:

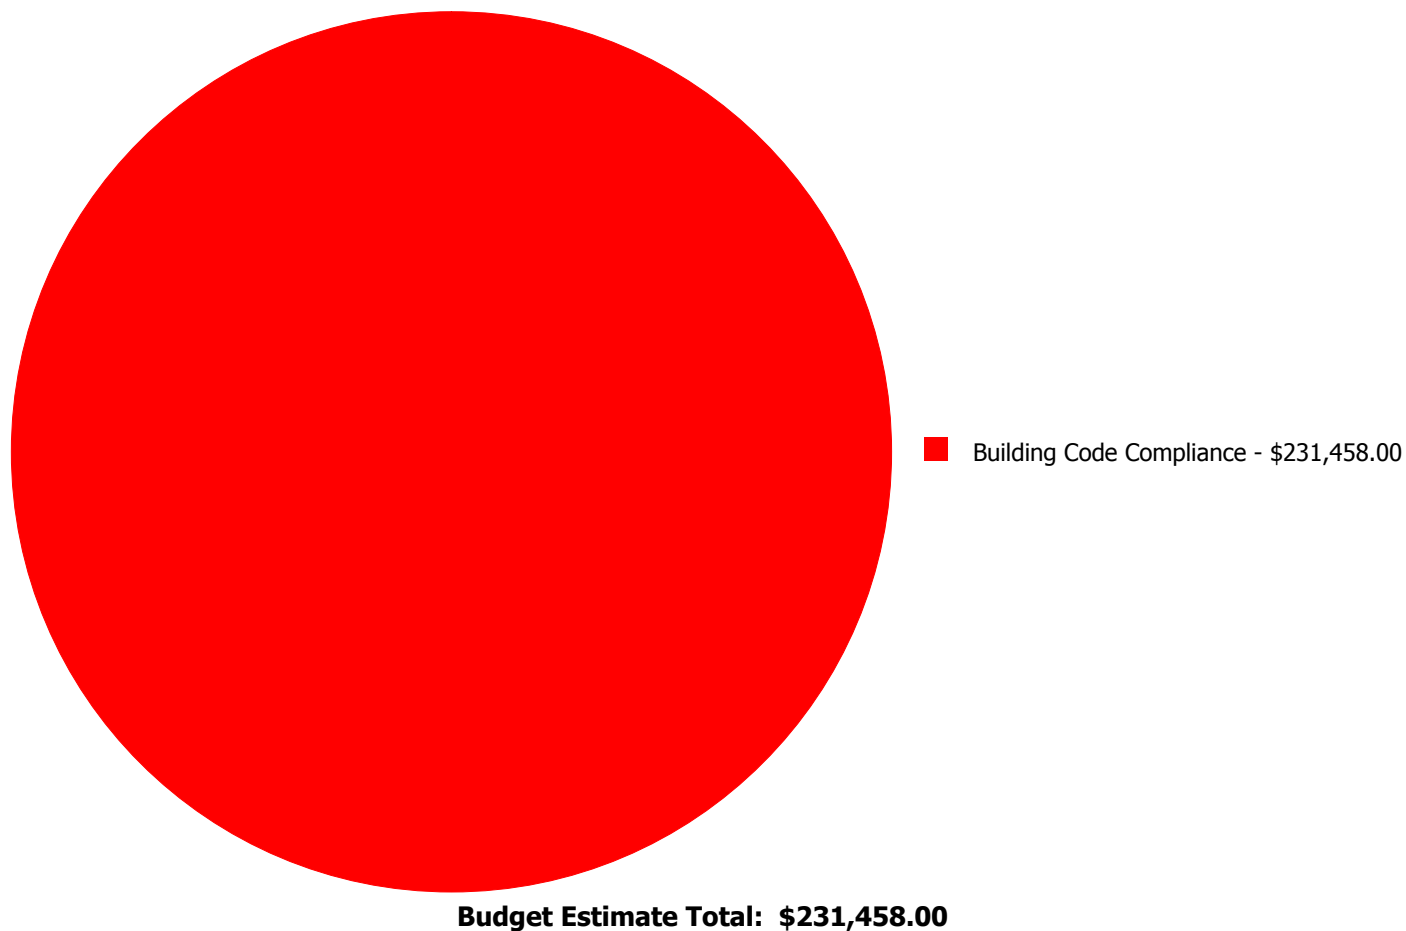
Deficiency Summary by Category

The following chart shows the total repair costs broken down by deficiency categories. Assessors assigned deficiencies to one of the following categories:

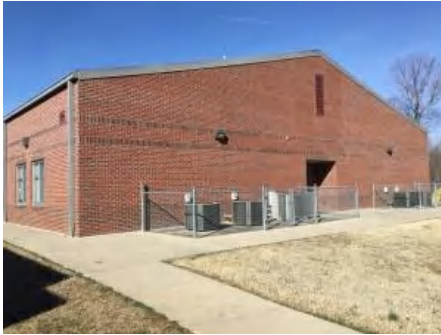
1). East Elevation - Feb 09, 2017

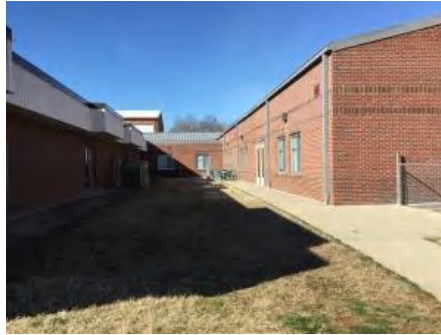
2). South Elevation - Feb 09, 2017

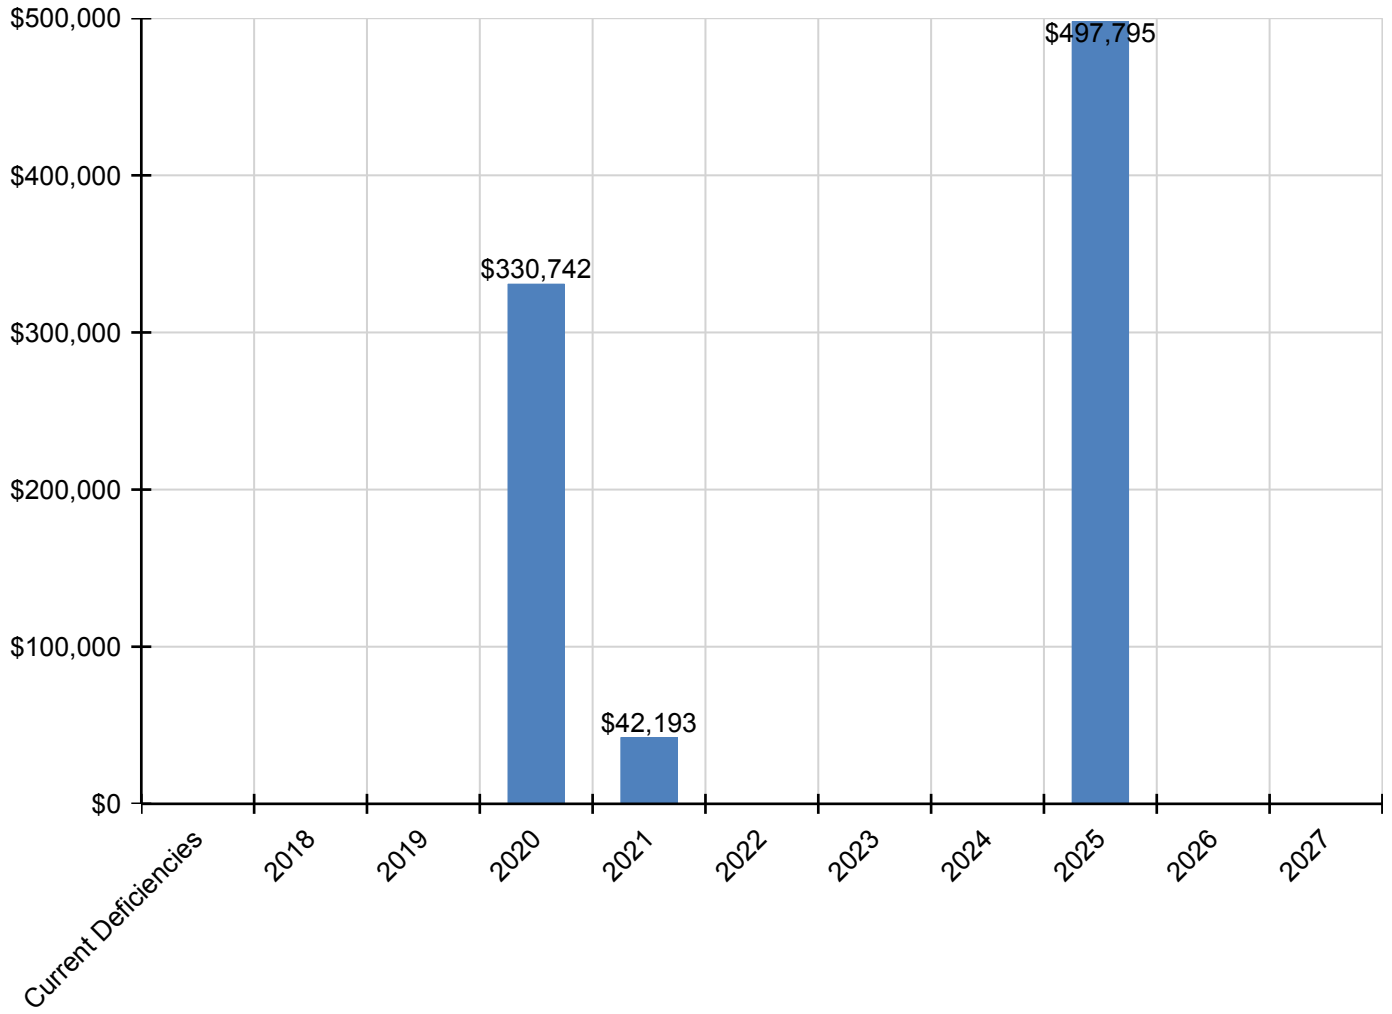
Forecasted Capital Renewal Requirement

The following chart shows the current building deficiencies and forecasting capital renewal or sustainment requirements over the next ten years.

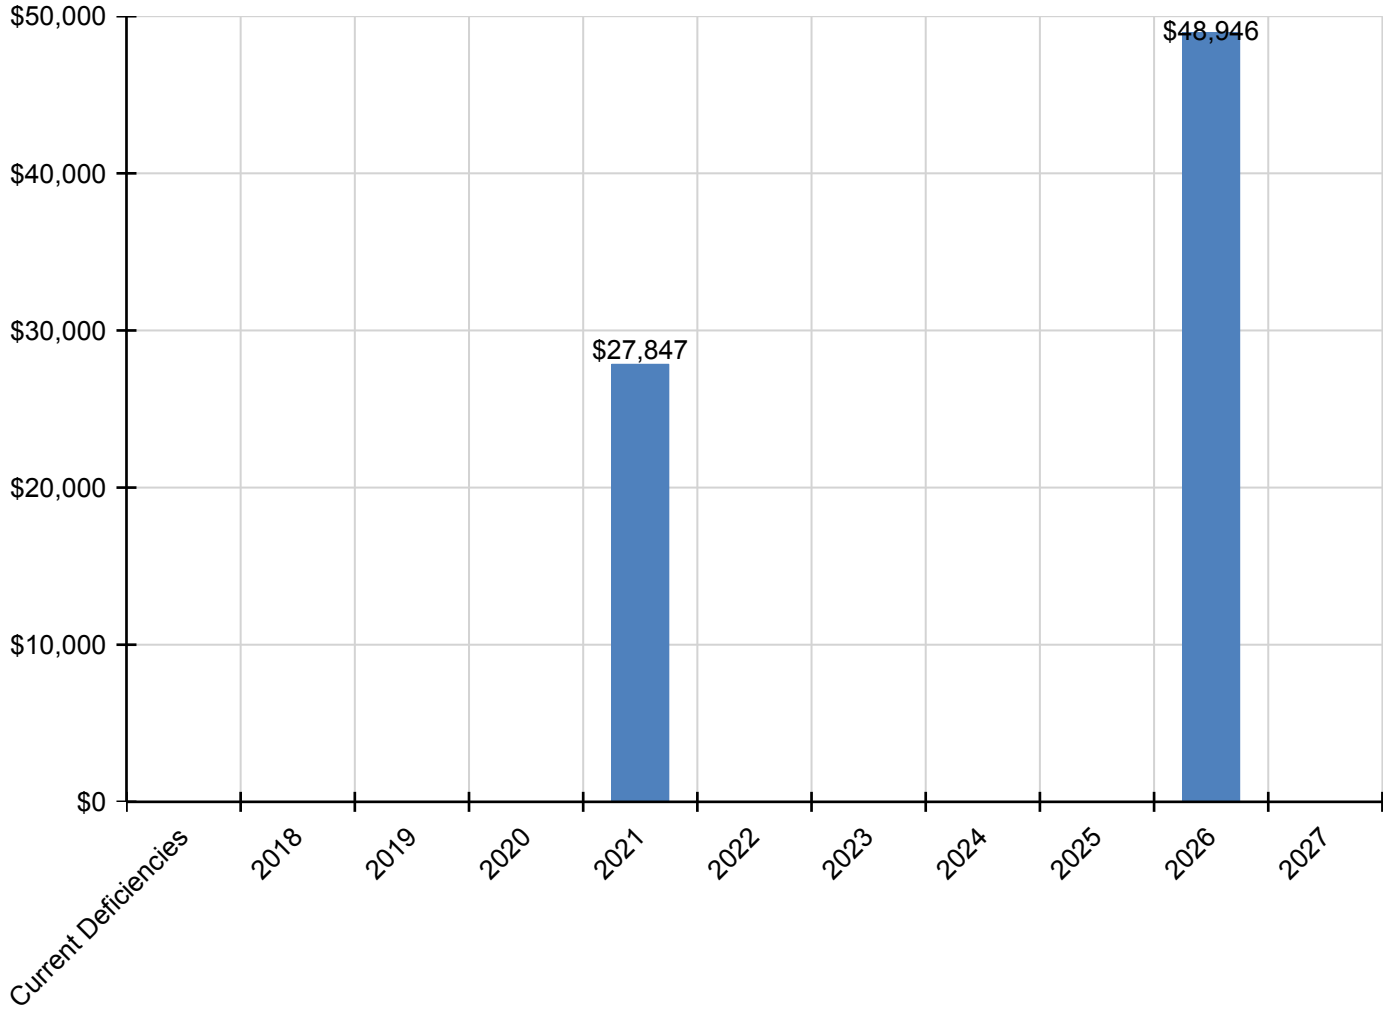
Forecasted Capital Renewal Requirement

The following chart shows the current building deficiencies and forecasting capital renewal or sustainment requirements over the next ten years.

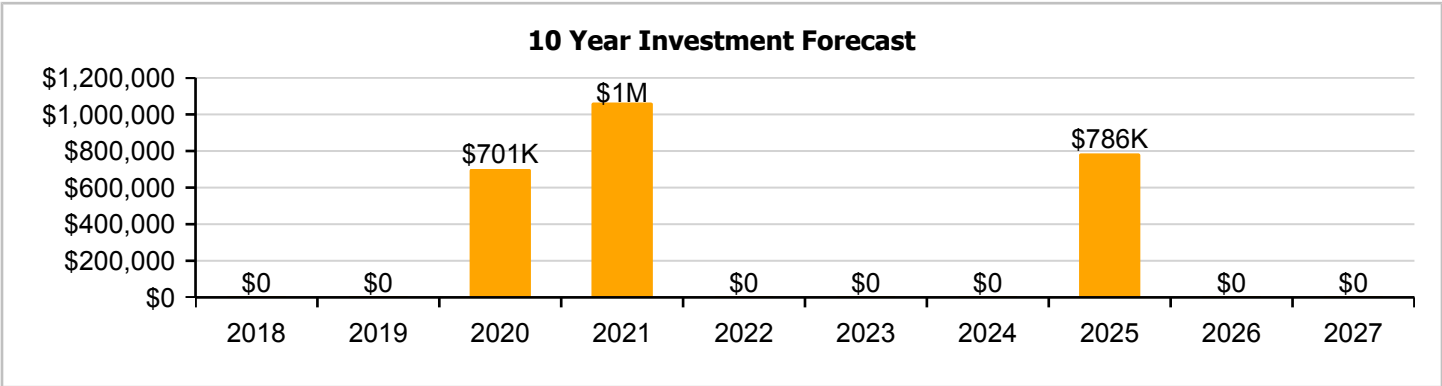
Function:		Gross Area:	84,666
Year Built:	1950	Last Renovation:	
Repair Cost:	\$0	Replacement Value:	\$2,555,219
FCI:	0.00 %	RSLI%:	20.33 %

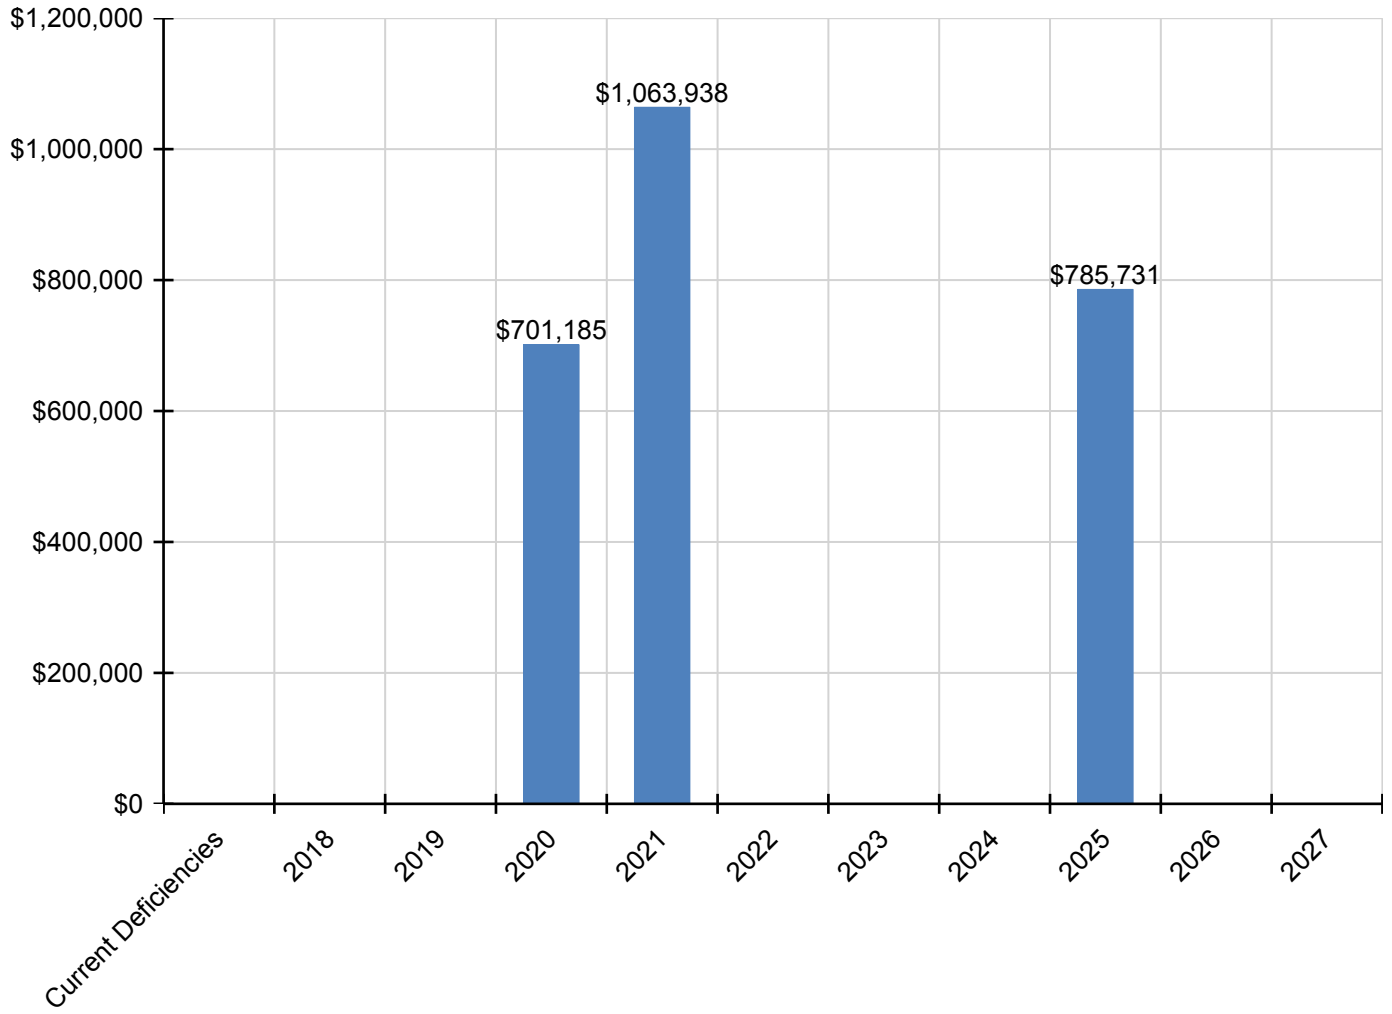
Forecasted Capital Renewal Requirement

The following chart shows the current building deficiencies and forecasting capital renewal or sustainment requirements over the next ten years.

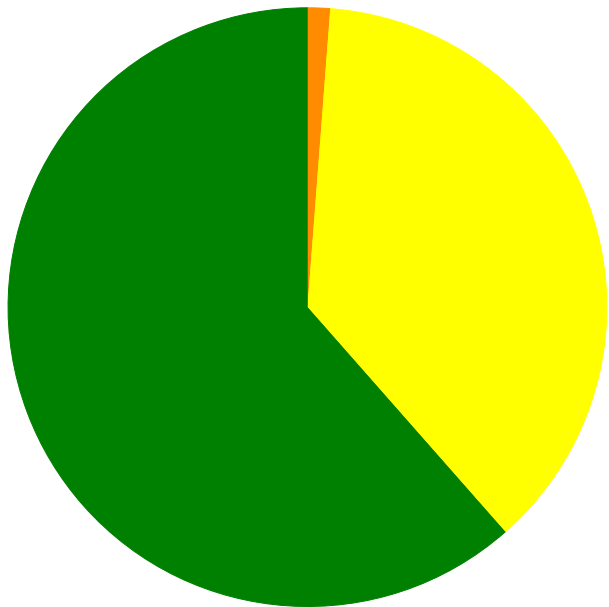
Deficiencies By Priority

- 1 - Currently Critical (Immediate)
- 2 - Potentially Critical (Year 1) - \$7,642.80
- 3 - Necessary/Not Yet Critical (Years 2-5) - \$234,914.00
- 4 - Recommended (Years 6-10) - \$387,290.00
- 5 - Codes or Standards Compliance

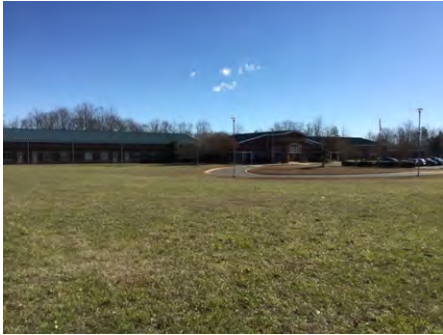
1). West Elevation - Feb 11, 2017

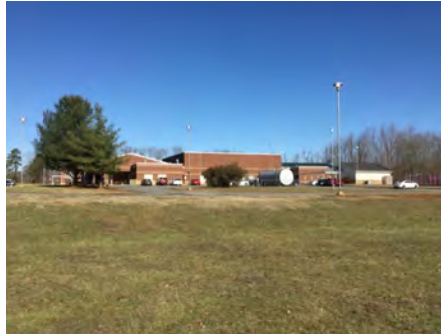
2). South Elevation - Feb 11, 2017

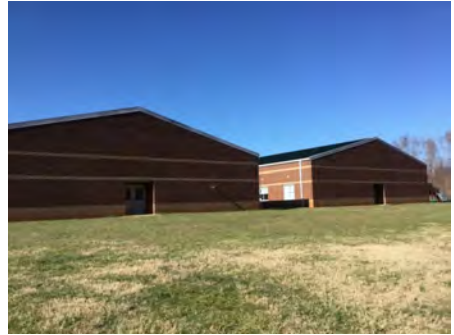
3). East Elevation - Feb 11, 2017

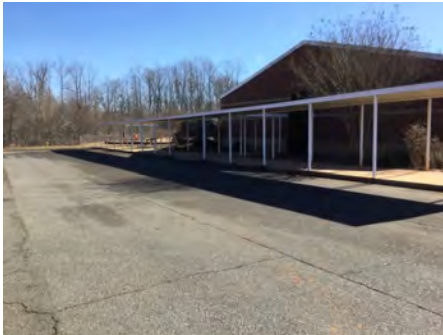
4). North Elevation - Feb 11, 2017

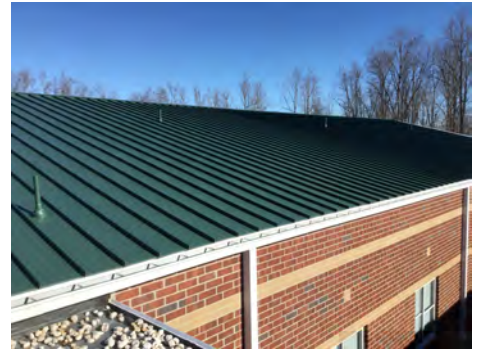
System: B3010130 - Preformed Metal Roofing

Note: Roof repainted in 2015 due to manufacturing defect

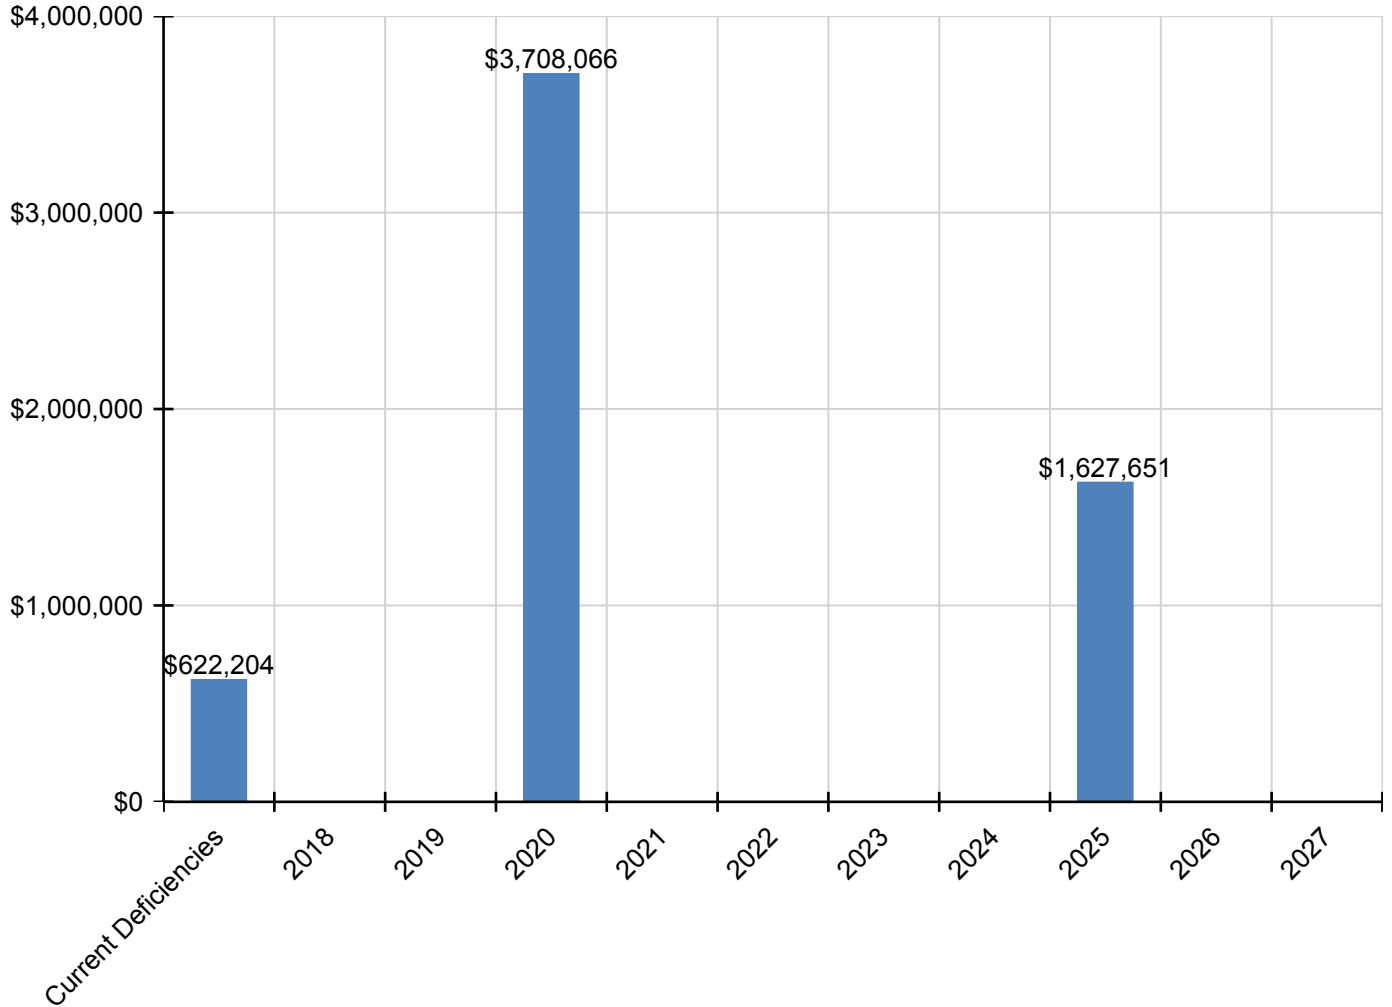
Forecasted Capital Renewal Requirement

The following chart shows the current building deficiencies and forecasting capital renewal or sustainment requirements over the next ten years.

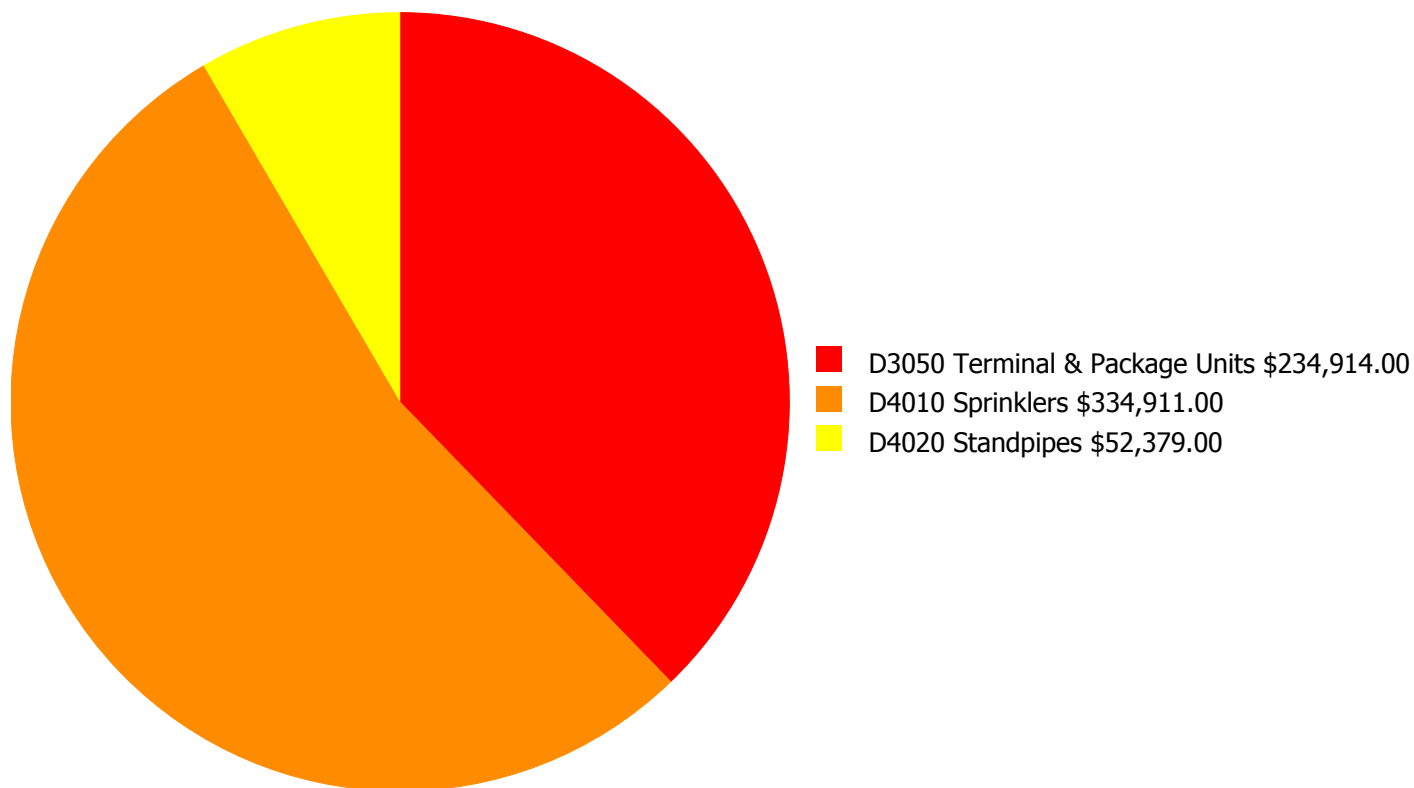
Deficiency Summary by System

Current deficiencies included assemblies that have reached or exceeded their design life or components of the assemblies that are in need of repair. Assemblies that have reached their design life are identified as current deficiencies and assigned the distress 'Beyond Useful Life'. The following chart lists all current deficiencies associated with this facility.

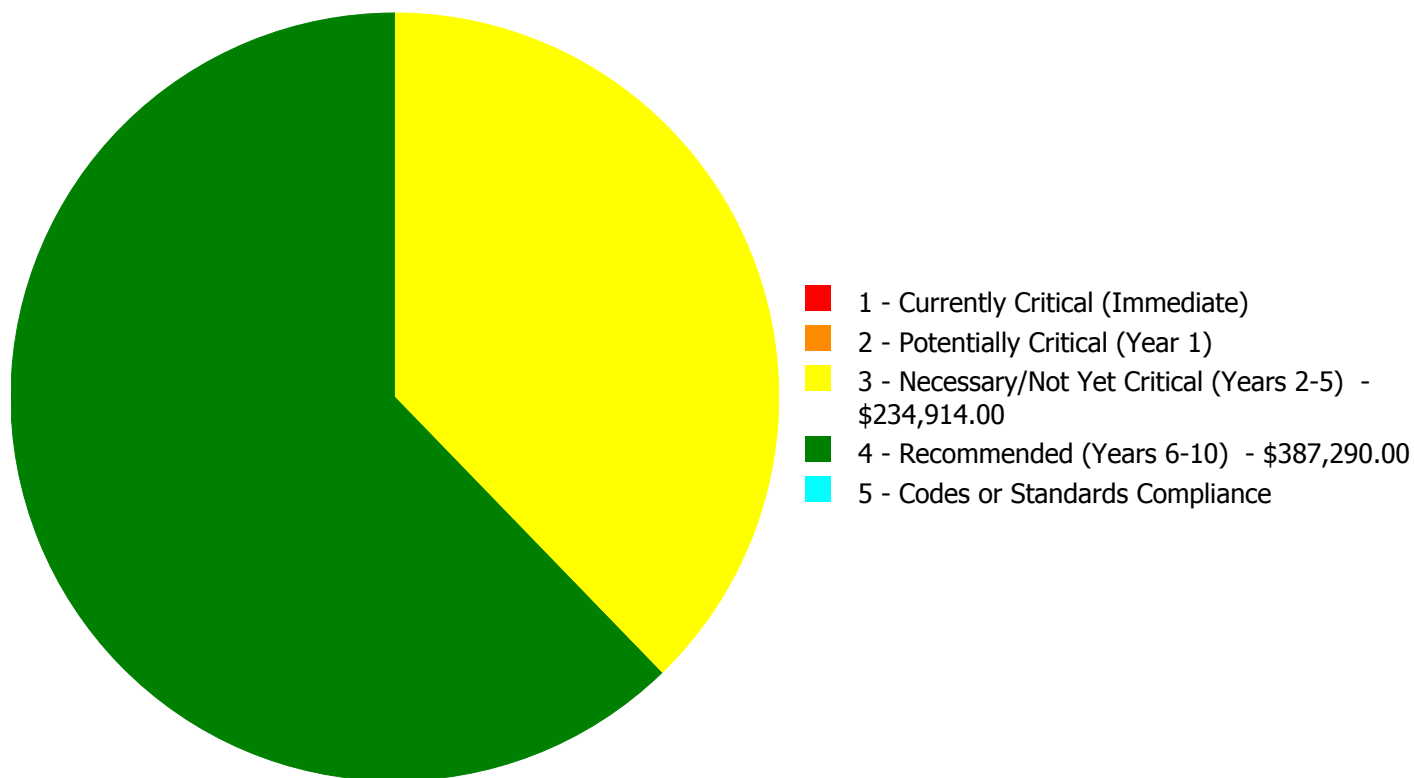
Deficiency Summary by Priority

The following chart shows the total repair costs broken down by priority. Assessors assigned deficiencies within eCOMET to one of the following priority categories:
