NC School District/300 Davie County/High School

Central Davie Academy

Campus Assessment Report

March 7, 2017

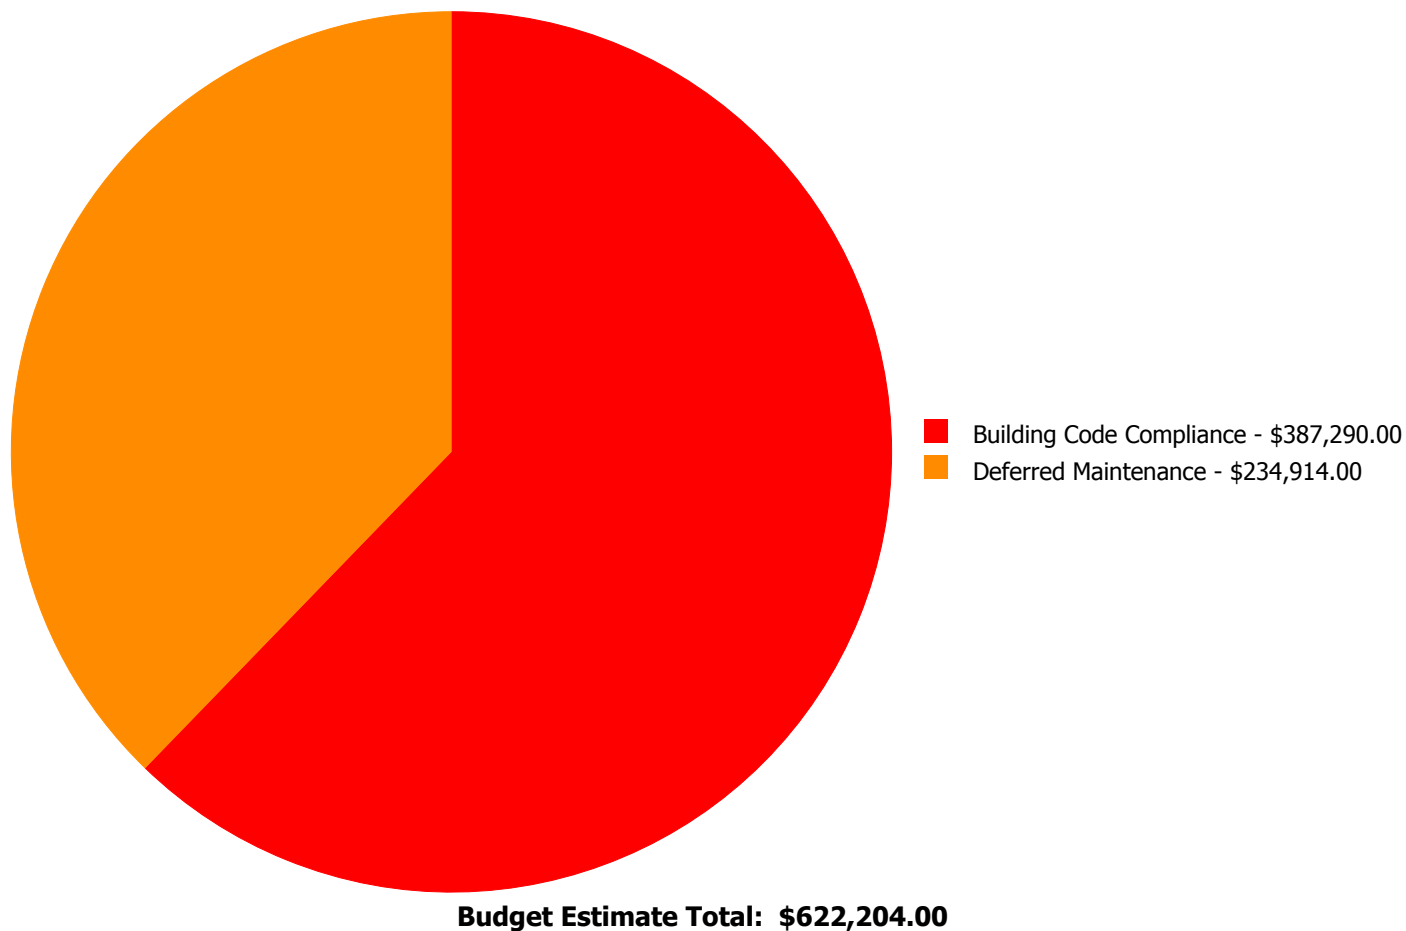
Deficiency Summary by Category

The following chart shows the total repair costs broken down by deficiency categories. Assessors assigned deficiencies to one of the following categories:

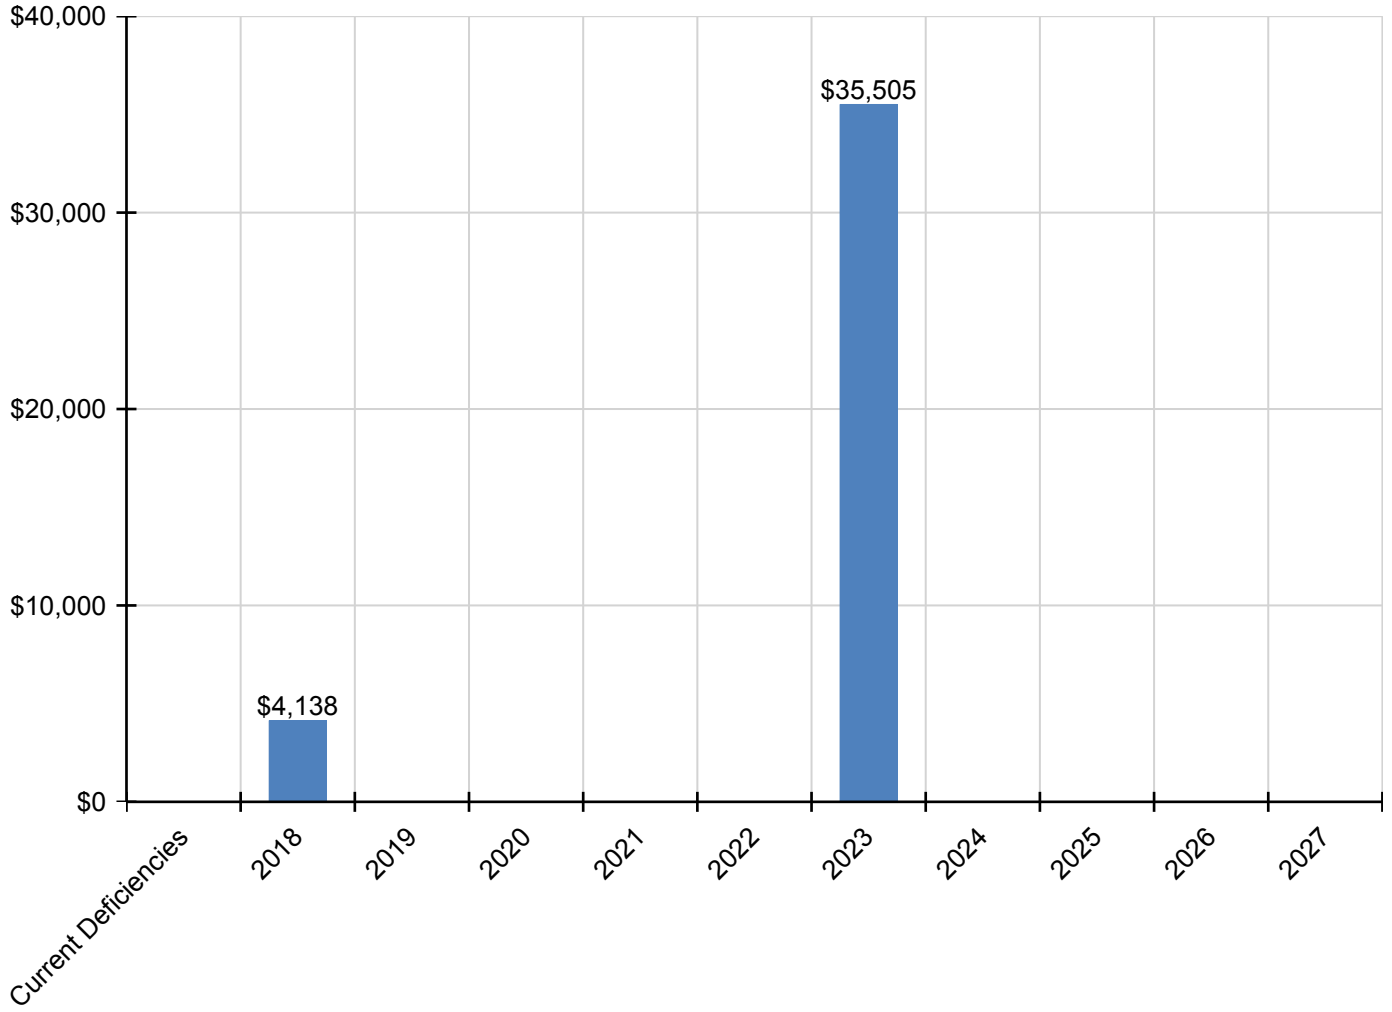
Forecasted Capital Renewal Requirement

The following chart shows the current building deficiencies and forecasting capital renewal or sustainment requirements over the next ten years.

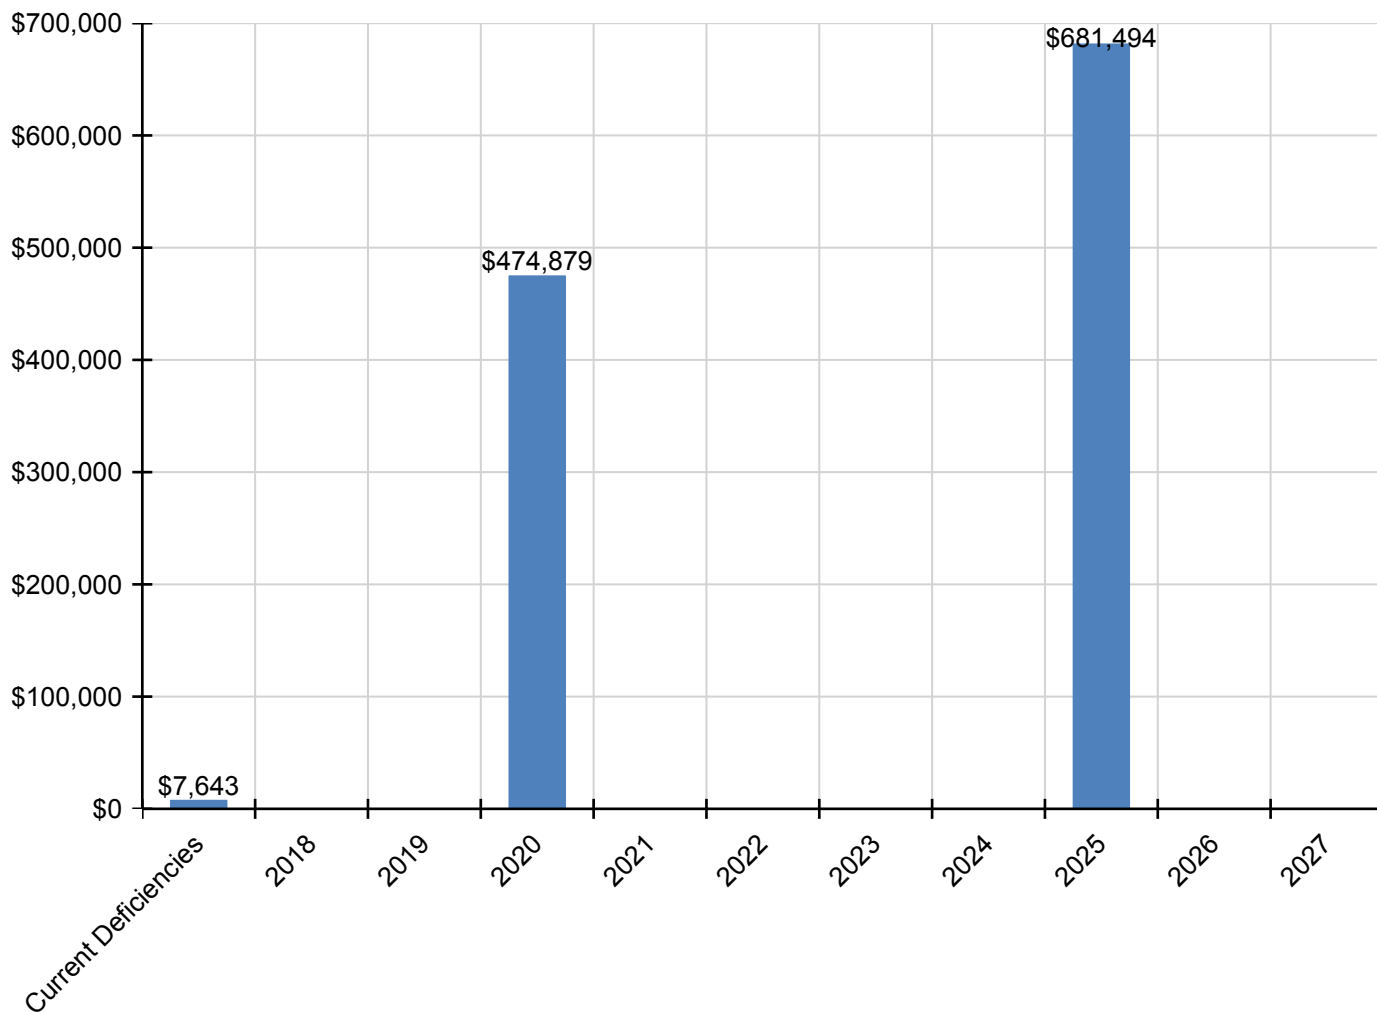
Forecasted Capital Renewal Requirement

The following chart shows the current building deficiencies and forecasting capital renewal or sustainment requirements over the next ten years.

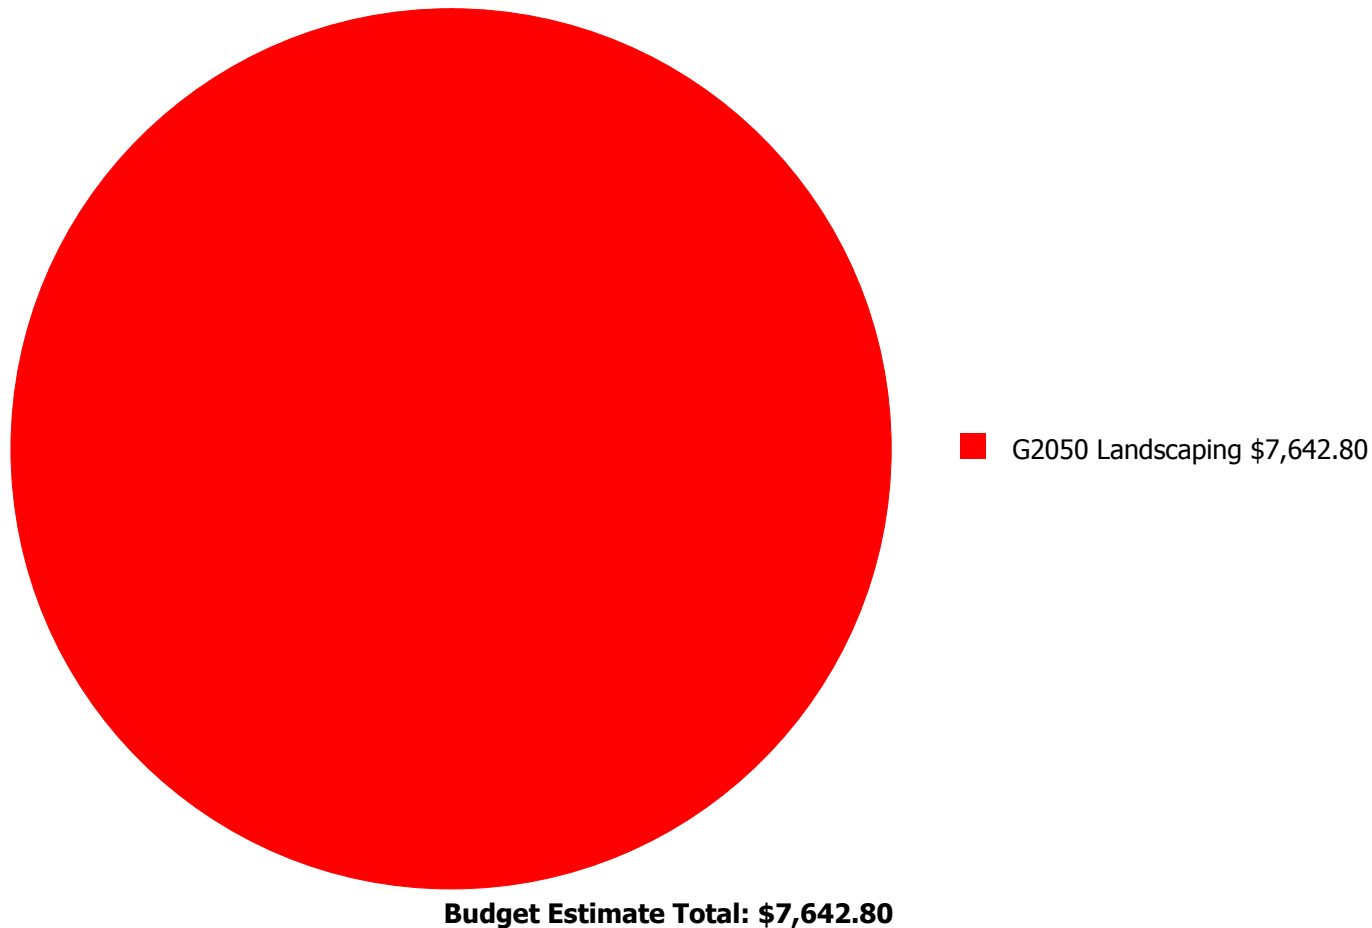
Deficiency Summary by System

Current deficiencies included assemblies that have reached or exceeded their design life or components of the assemblies that are in need of repair. Assemblies that have reached their design life are identified as current deficiencies and assigned the distress 'Beyond Useful Life'. The following chart lists all current deficiencies associated with this facility.

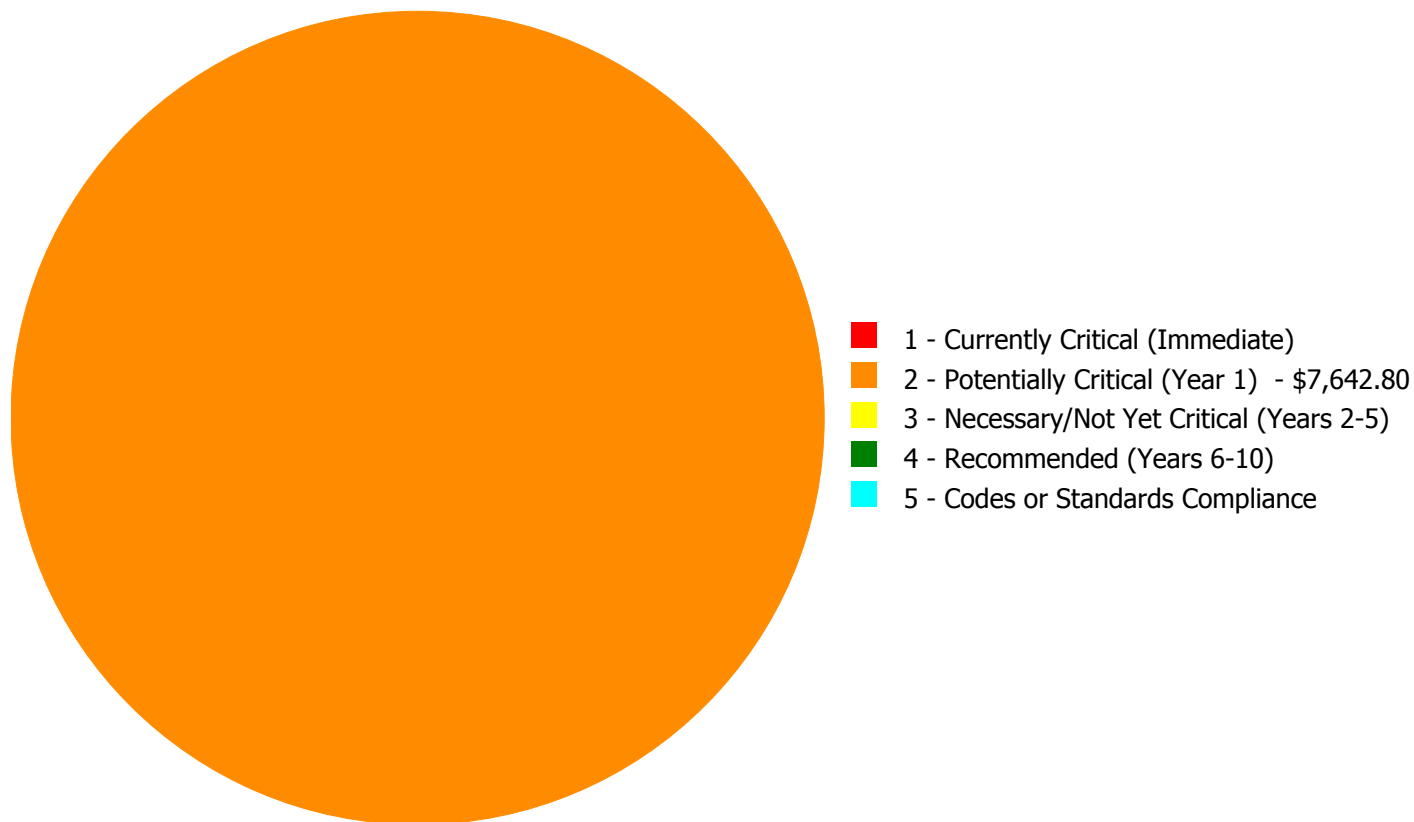
Deficiency Summary by Priority

The following chart shows the total repair costs broken down by priority. Assessors assigned deficiencies within eCOMET to one of the following priority categories:

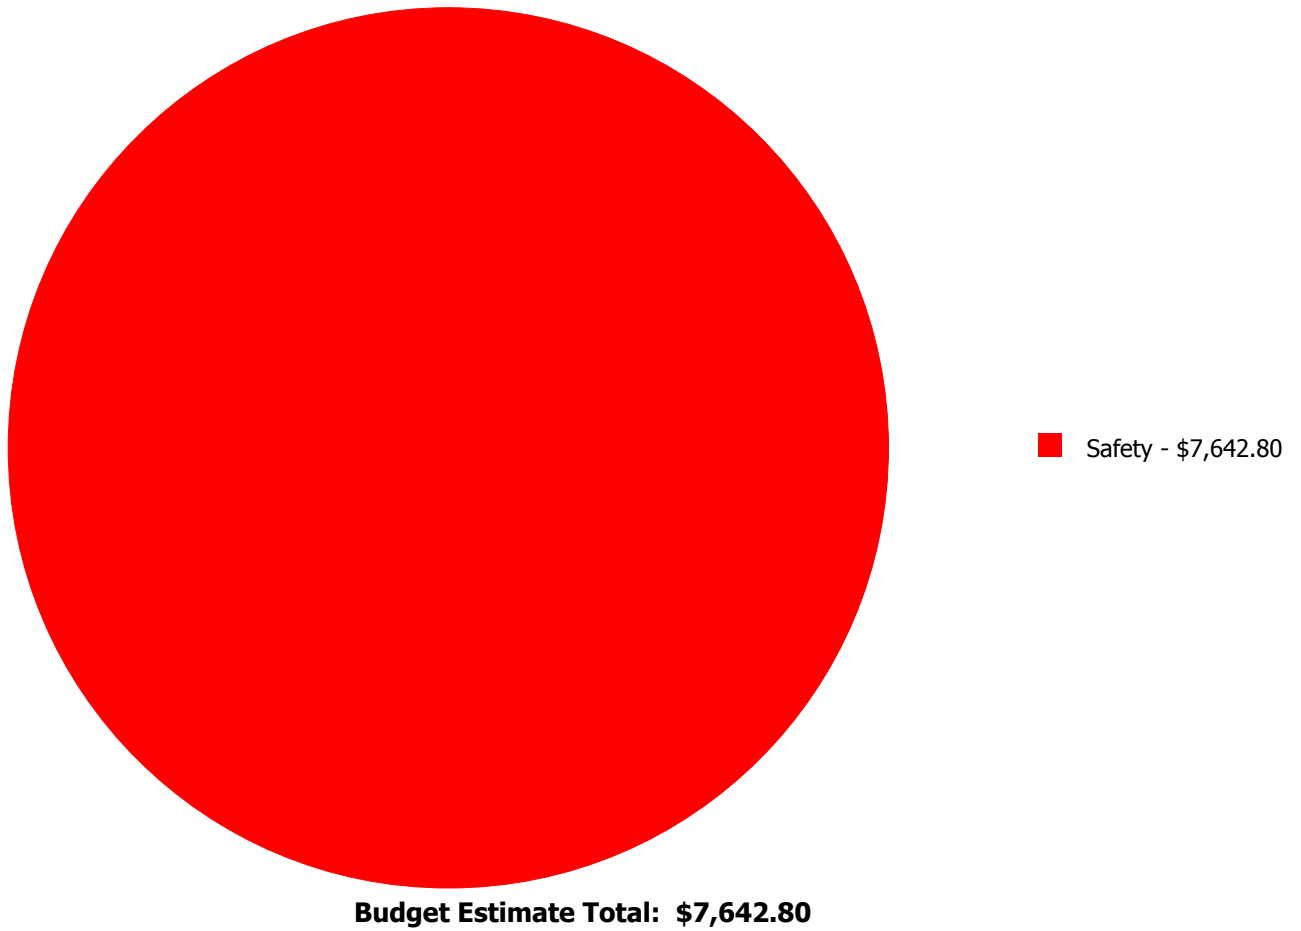
Deficiency Summary by Category

The following chart shows the total repair costs broken down by deficiency categories. Assessors assigned deficiencies to one of the following categories:

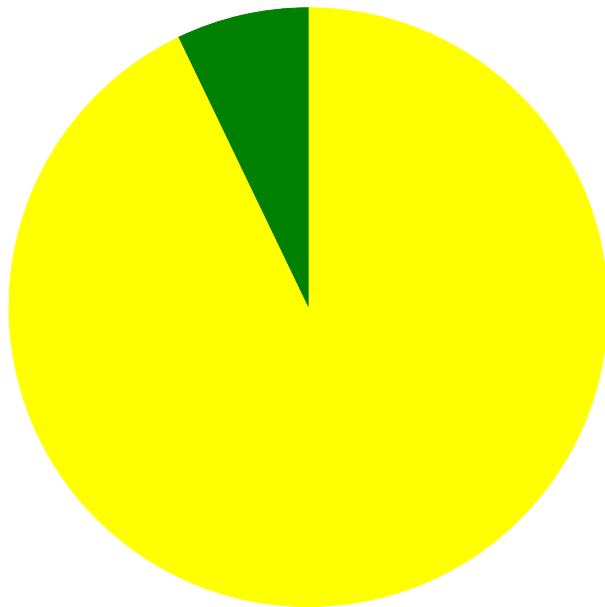
Deficiencies By Priority

- 1 - Currently Critical (Immediate)
- 2 - Potentially Critical (Year 1)
- 3 - Necessary/Not Yet Critical (Years 2-5) - \$4,283,170.96
- 4 - Recommended (Years 6-10) - \$329,085.00
- 5 - Codes or Standards Compliance

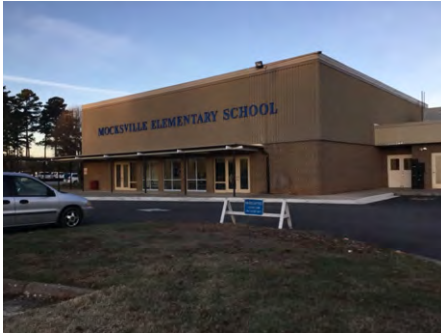
1). East Elevation - Mar 06, 2017

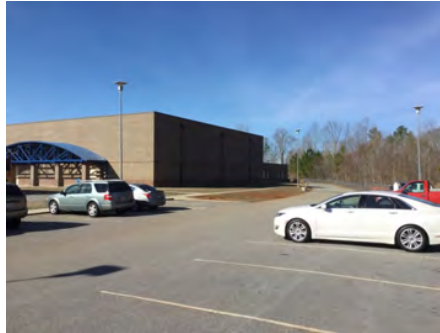
2). North Elevation - Mar 06, 2017

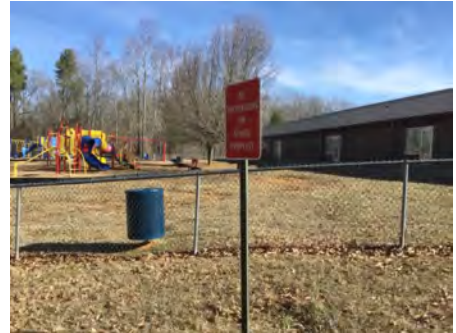
3). West Elevation - Mar 06, 2017

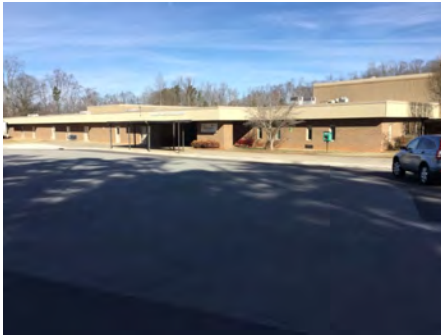
4). South Elevation - Mar 06, 2017

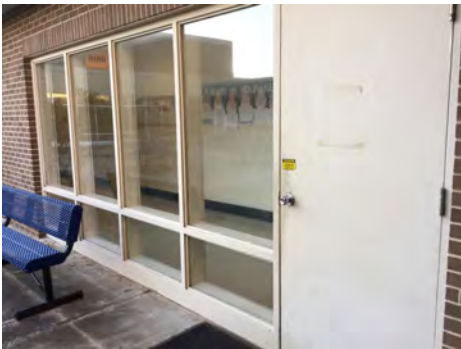
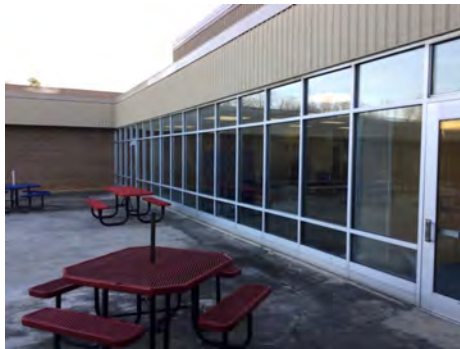
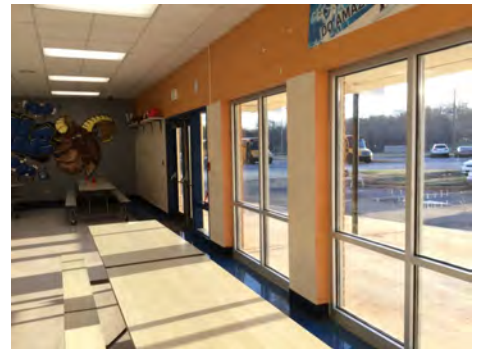
System: B2020 - Exterior Windows

Note: Aluminum framed windows appear to match gym addition and are therefore assumed new in 2005.

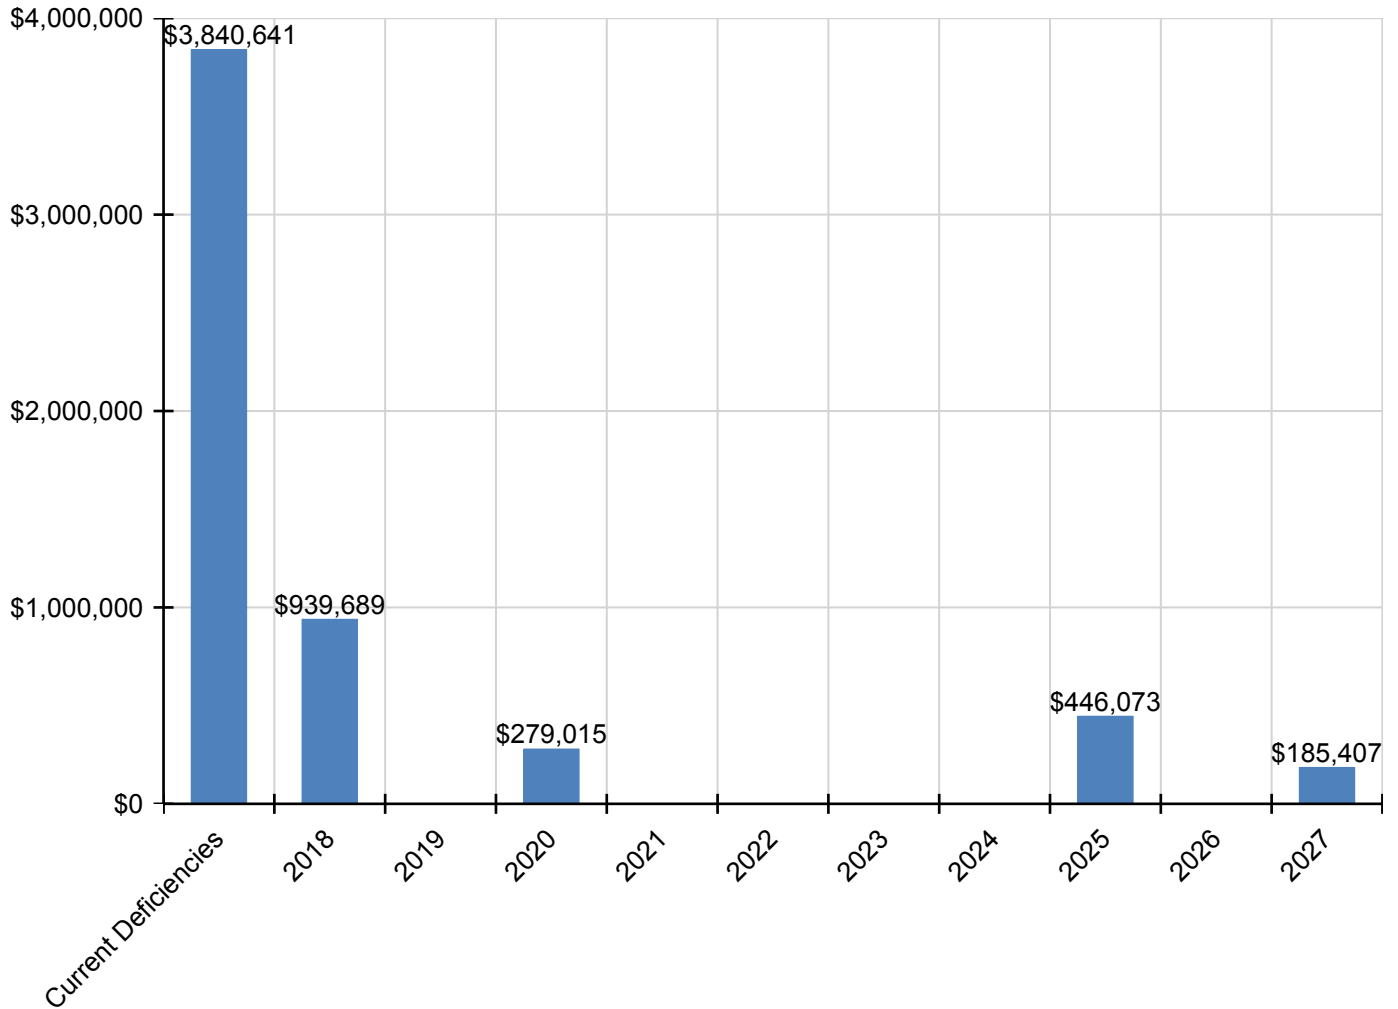
Forecasted Capital Renewal Requirement

The following chart shows the current building deficiencies and forecasting capital renewal or sustainment requirements over the next ten years.

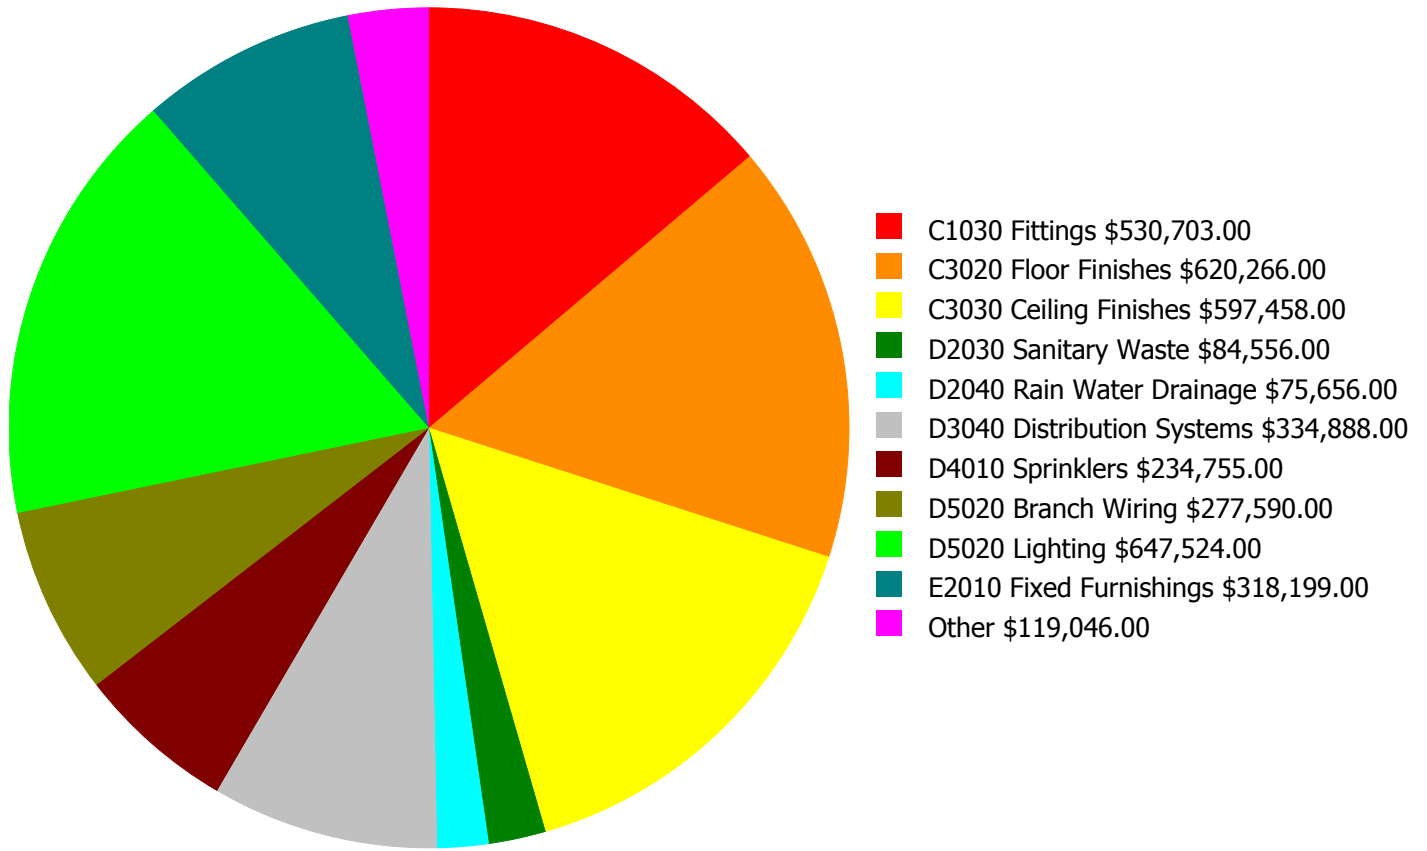
Deficiency Summary by System

Current deficiencies included assemblies that have reached or exceeded their design life or components of the assemblies that are in need of repair. Assemblies that have reached their design life are identified as current deficiencies and assigned the distress 'Beyond Useful Life'. The following chart lists all current deficiencies associated with this facility.

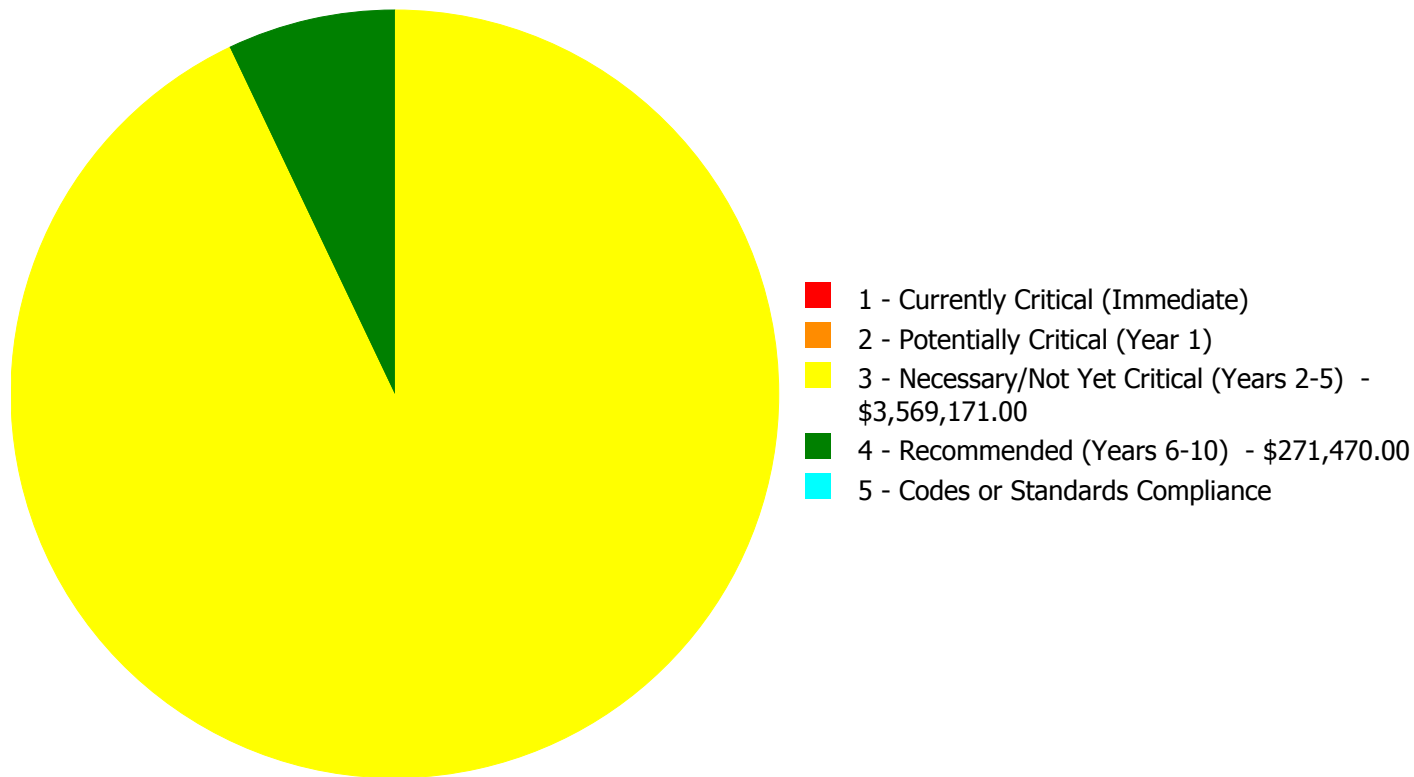
Deficiency Summary by Priority

The following chart shows the total repair costs broken down by priority. Assessors assigned deficiencies within eCOMET to one of the following priority categories:

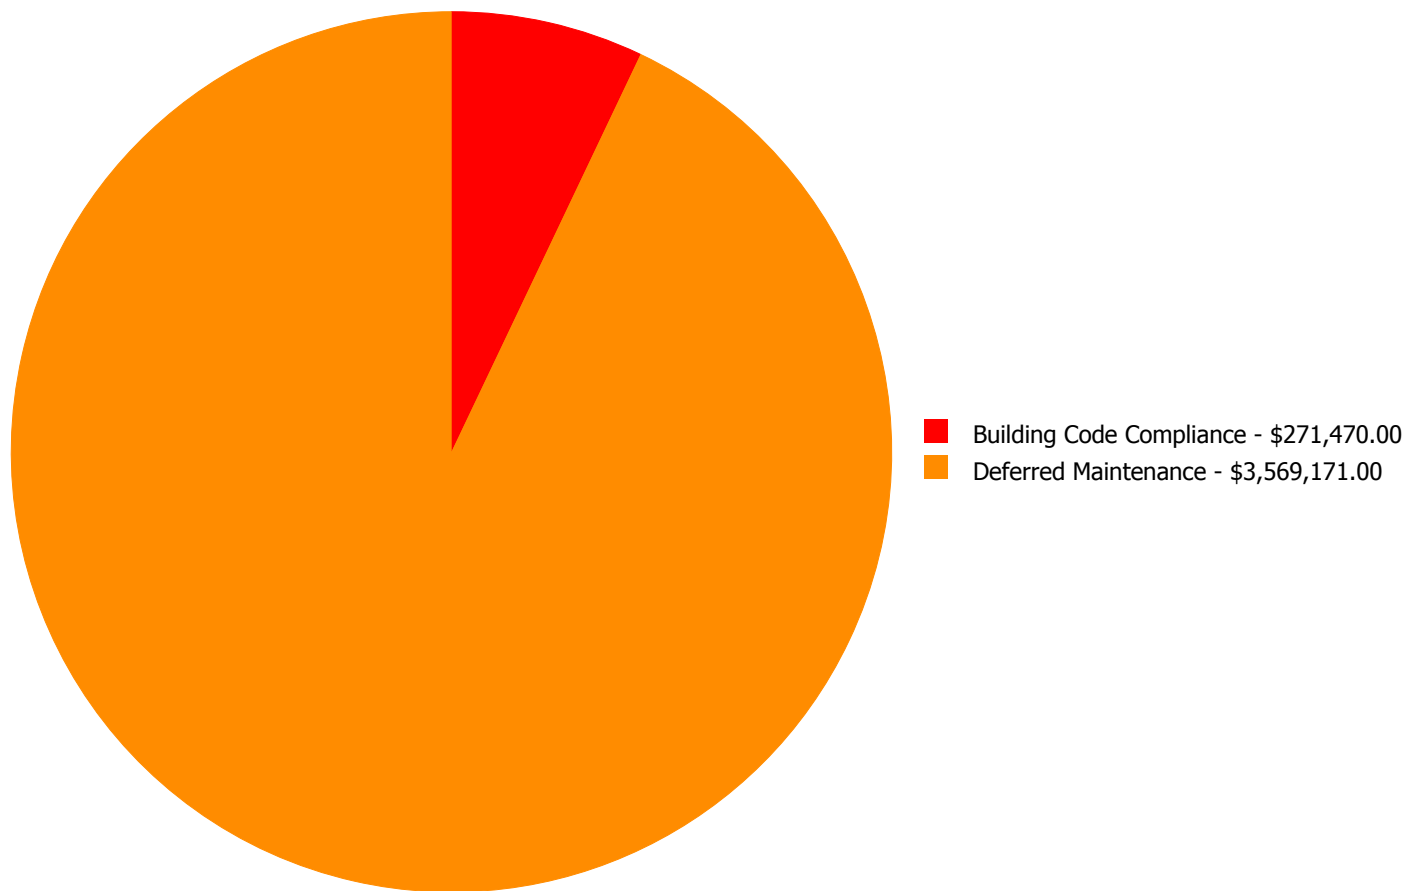
Deficiency Summary by Category

The following chart shows the total repair costs broken down by deficiency categories. Assessors assigned deficiencies to one of the following categories:

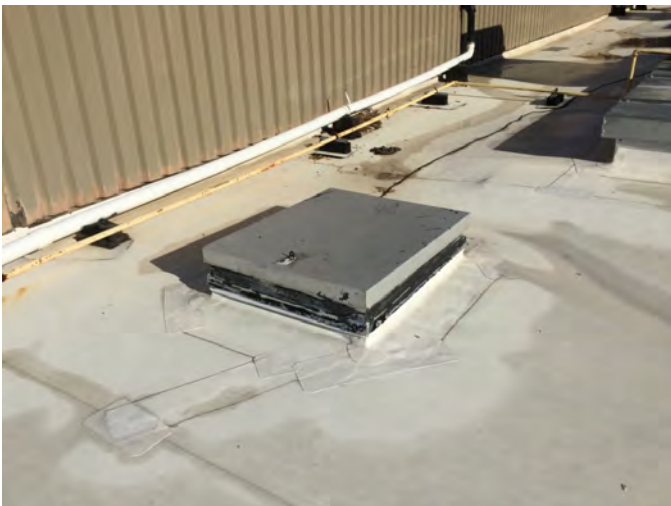
System: B3020 - Roof Openings

Location: Roof
Distress: Beyond Service Life
Category: Deferred Maintenance
Priority: 3 - Necessary/Not Yet Critical (Years 2-5)
Correction: Renew System
Qty: 50,572.00
Unit of Measure: S.F.
Estimate: \$16,132.00
Assessor Name: Ann Buerger Linden
Date Created: 02/14/2017

Notes: The roof hatch is beyond its expected life. Replacement is recommended.

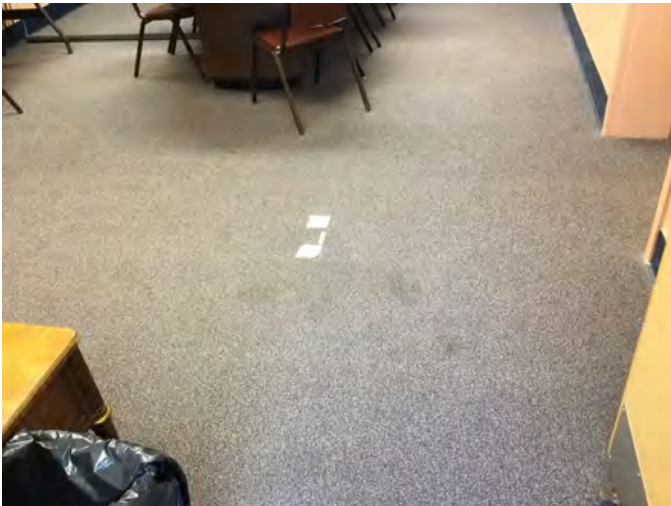
System: C3020 - Floor Finishes

Location: Throughout the building
Distress: Beyond Service Life
Category: Deferred Maintenance
Priority: 3 - Necessary/Not Yet Critical (Years 2-5)
Correction: Renew System
Qty: 50,572.00
Unit of Measure: S.F.
Estimate: \$620,266.00
Assessor Name: Ann Buerger Linden
Date Created: 02/14/2017

Notes: Carpet to VCT changes began in 1988 and is ongoing. Those early replacements, along with original VCT, are beyond their expected useful life. Asbestos containing mastic under VCT is reported to be present in the building. System renewal is recommended.

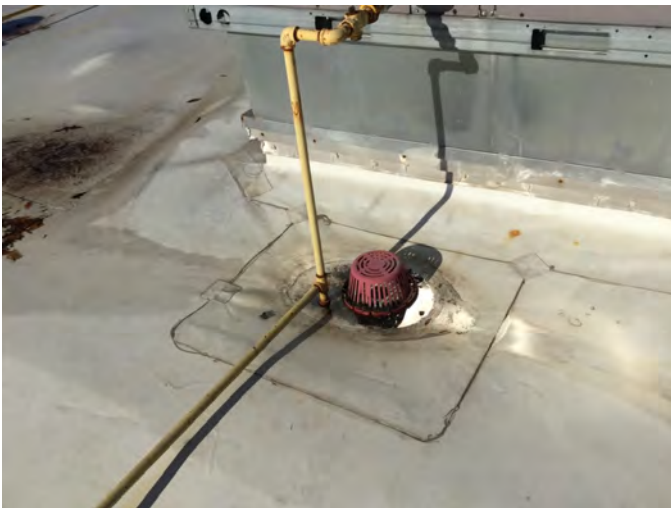
System: D2090 - Other Plumbing Systems -Nat Gas

Location: Roof, kitchen, EQ rooms
Distress: Beyond Service Life
Category: Deferred Maintenance
Priority: 3 - Necessary/Not Yet Critical (Years 2-5)
Correction: Renew System
Qty: 50,572.00
Unit of Measure: S.F.
Estimate: \$9,457.00
Assessor Name: Ann Buerger Linden
Date Created: 02/14/2017

Notes: Natural gas piping is presumed to be original and is there beyond its expected useful life. System renewal is recommended.

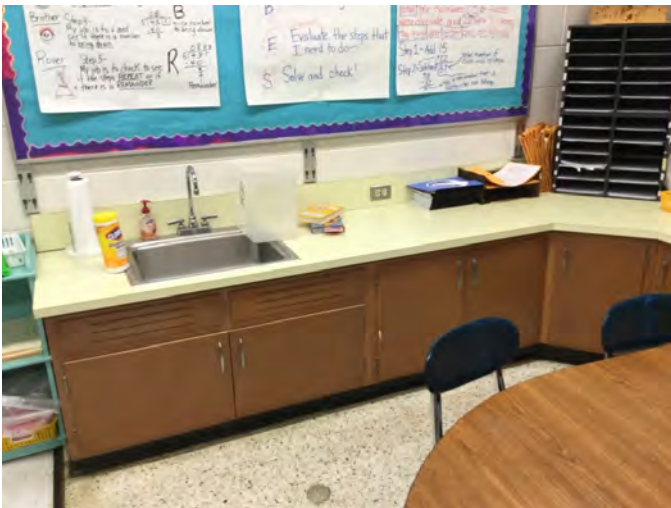
System: D5020 - Branch Wiring

Location: Throughout the building
Distress: Beyond Service Life
Category: Deferred Maintenance
Priority: 3 - Necessary/Not Yet Critical (Years 2-5)
Correction: Renew System
Qty: 50,572.00
Unit of Measure: S.F.
Estimate: \$277,590.00
Assessor Name: Ann Buerger Linden
Date Created: 02/14/2017

Notes: The branch wiring system is mostly original and well beyond its expected useful life. GFI outlets were not seen in all wet areas. System renewal is recommended.

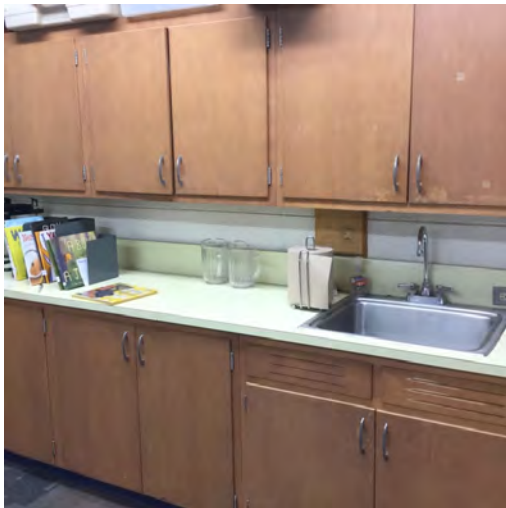
System: E2010 - Fixed Furnishings

Location: Throughout the building
Distress: Beyond Service Life
Category: Deferred Maintenance
Priority: 3 - Necessary/Not Yet Critical (Years 2-5)
Correction: Renew System
Qty: 50,572.00
Unit of Measure: S.F.
Estimate: \$318,199.00
Assessor Name: Ann Buerger Linden
Date Created: 02/14/2017

Notes: Fixed furnishings are typically original and in worn condition with stains, veneer damage etc. System renewal is recommended.

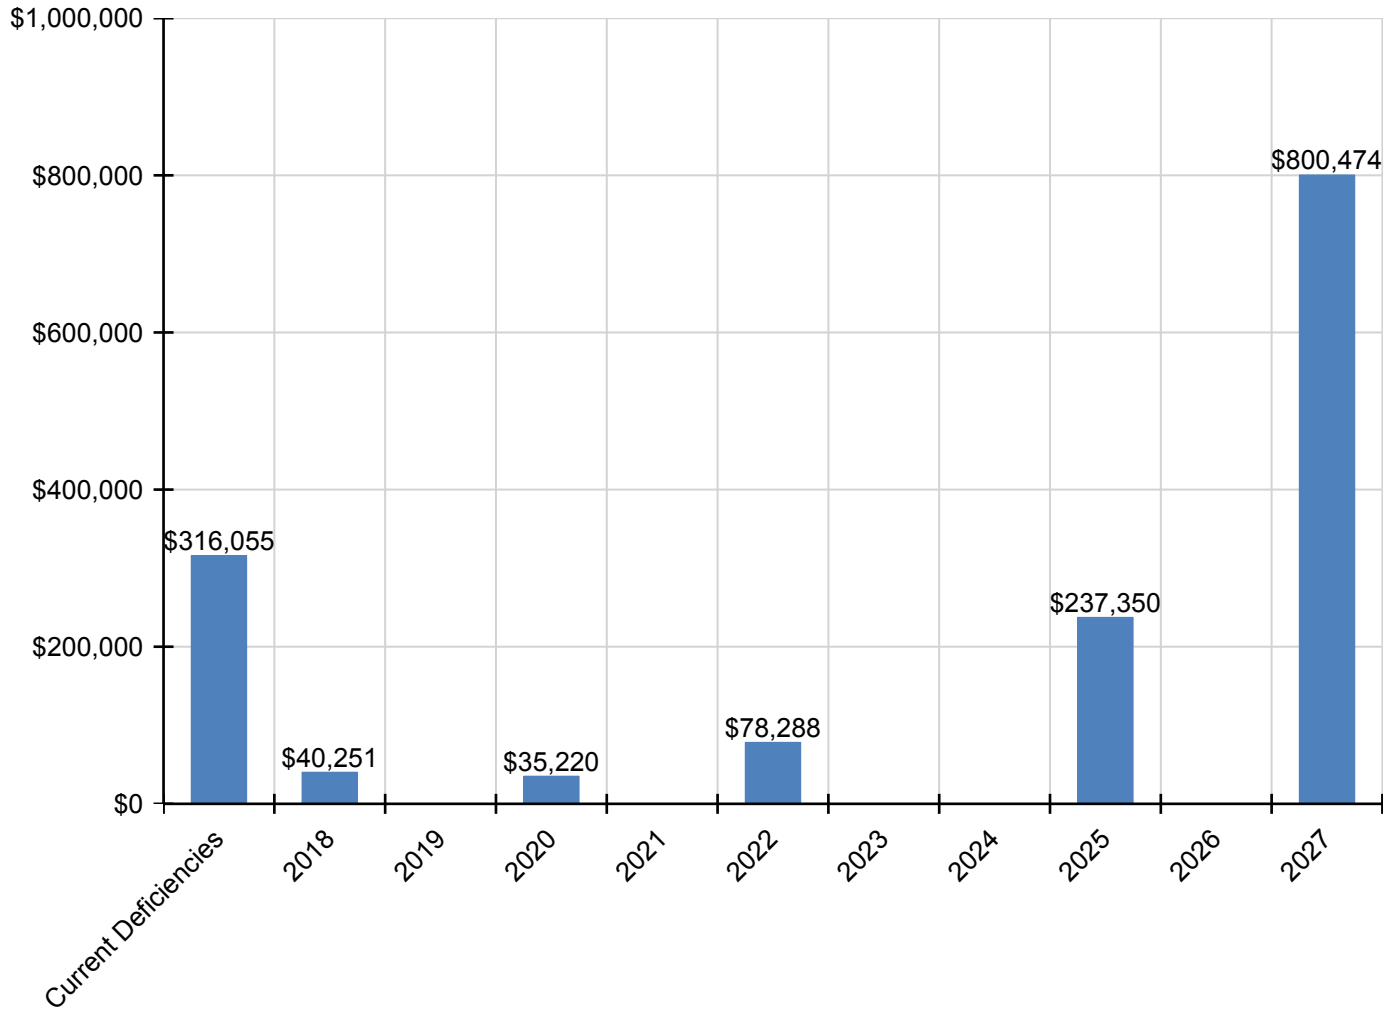
Forecasted Capital Renewal Requirement

The following chart shows the current building deficiencies and forecasting capital renewal or sustainment requirements over the next ten years.

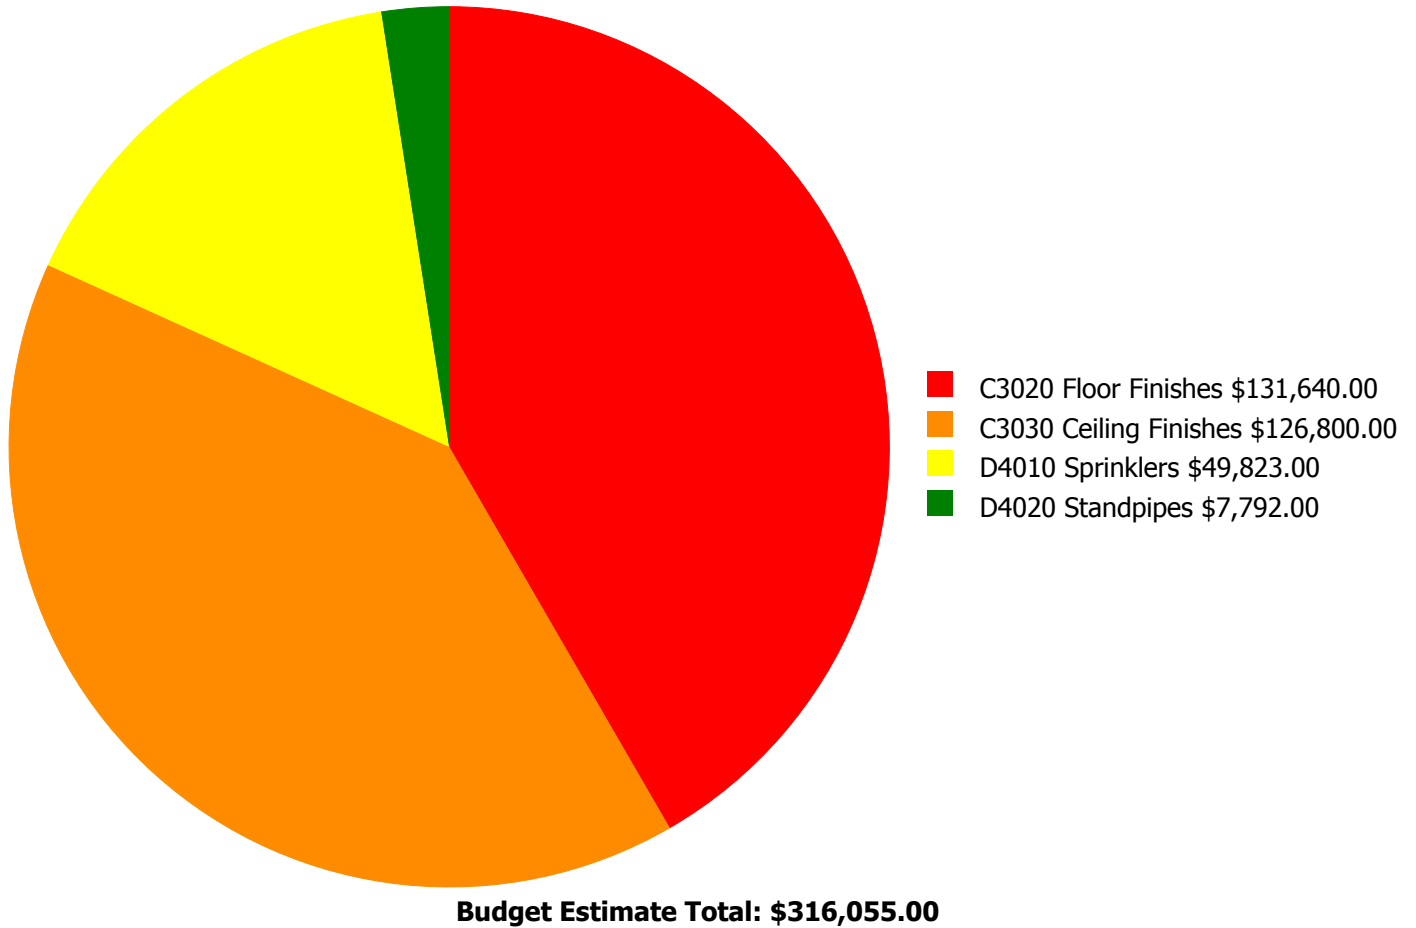
Deficiency Summary by System

Current deficiencies included assemblies that have reached or exceeded their design life or components of the assemblies that are in need of repair. Assemblies that have reached their design life are identified as current deficiencies and assigned the distress 'Beyond Useful Life'. The following chart lists all current deficiencies associated with this facility.

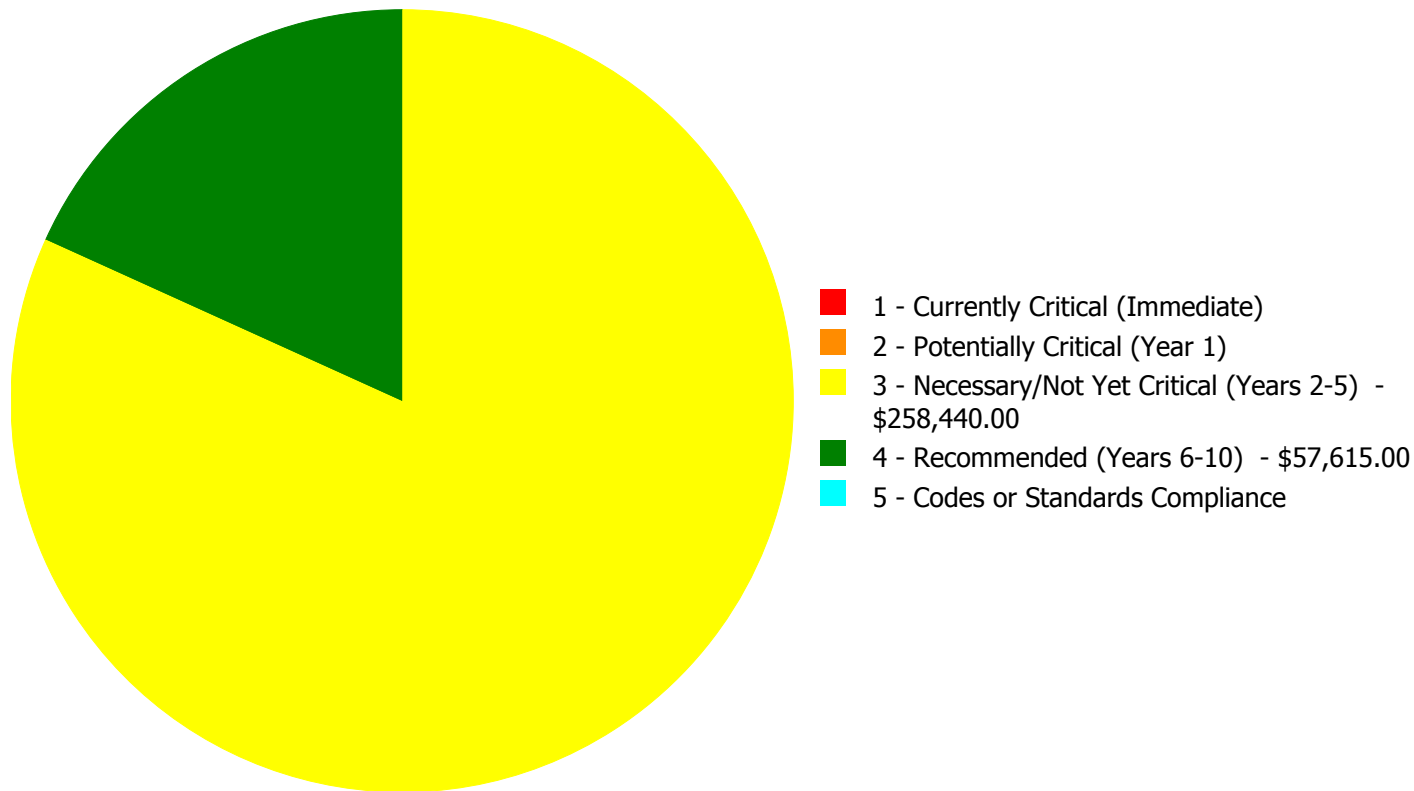
Deficiency Summary by Priority

The following chart shows the total repair costs broken down by priority. Assessors assigned deficiencies within eCOMET to one of the following priority categories:

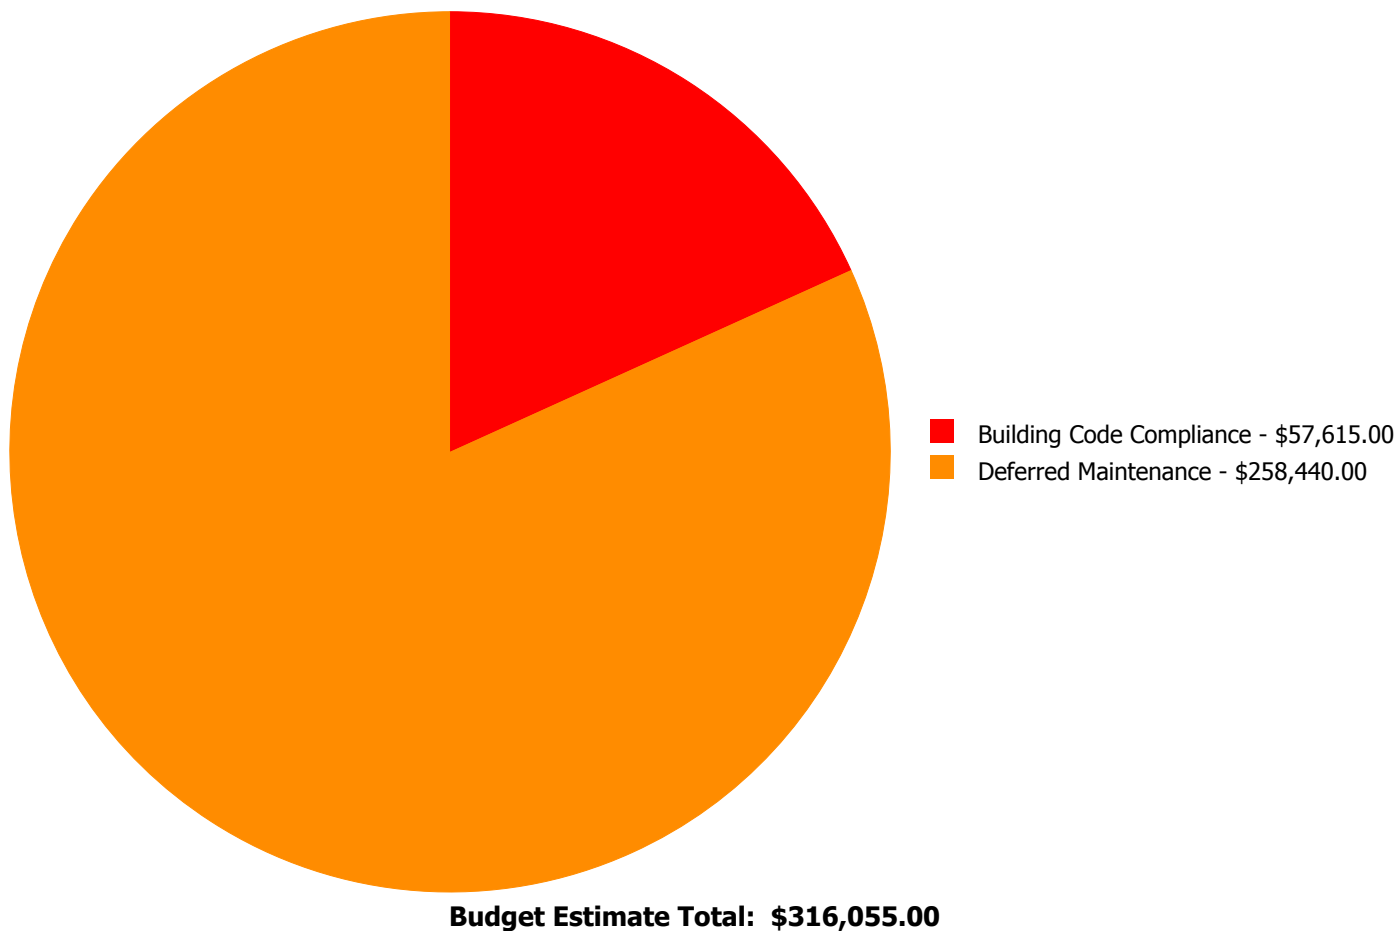
Deficiency Summary by Category

The following chart shows the total repair costs broken down by deficiency categories. Assessors assigned deficiencies to one of the following categories:

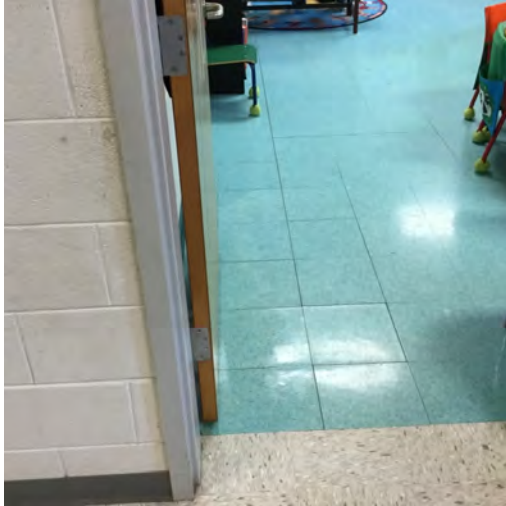
System: C3020 - Floor Finishes

Location: Throughout the building
Distress: Beyond Service Life
Category: Deferred Maintenance
Priority: 3 - Necessary/Not Yet Critical (Years 2-5)
Correction: Renew System
Qty: 10,733.00
Unit of Measure: S.F.
Estimate: \$131,640.00
Assessor Name: Somnath Das
Date Created: 02/14/2017

Notes: Floor finishes are typically original and beyond their expected useful life. Joints in VCT are opening up. Some classrooms still have carpet where VCT is preferred. System renewal is recommended.
